**Flood Control Project Maintenance
Levee Inspections**

Maintenance Issue Types Only, Levee Inspection Report By Mile - Fall 2023

Butte County Department of Public Works

Waterway	Bank	Unit Miles	Inspection Start/End	Inspector
Unit No. 01 Mud Creek	Right	6.80	10/11/2023 10/11/2023	Makar Sokol

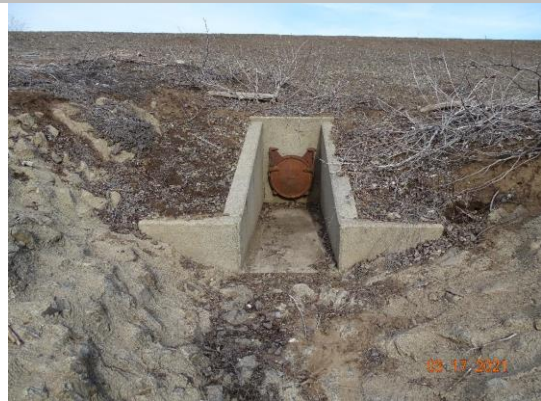
Photo 2 of 3 : UCIP_FA_2023_77889_99225.jpg

Comment Code						
Inspector Comment						
DS_ID:19209						
FS_ID:77889						
EP_NO: N/A						
Repair Type: Non-Urgent						
EVAL Issue:						
Crossing Status: Found						
UCIP Comments: 12/19/2022 Record updated from Urgent to Non-Urgent. Pipe has been CIPP-lined. LOF of crossing is less or equal to 4. Recommend next video inspection in 5 years. (O.Yakimov - DWR UCIP).						
03/17/2021 Record updated from No Action Needed to Urgent. DMP internal video inspection has found pipe integrity issues. LOF of crossing is between 5 and 6. Crossing will be monitored until funding becomes available to address the issues. No permit has been identified authorizing pipe. (O.Yakimov - DWR UCIP)						
02/20/2014 Looks cleaned recently. (P. Amatya - DWR UCIP)						
FIELD_STRUCT_DESC: 24-inch CIPP-lined corrugated metal gravity drainage pipe through the levee, 12.5 feet below the crown. Flap gate on the waterside (WS) end. Concrete U-shaped headwall on each end. Grouted riprap apron on the landside (LS) end. Grouted riprap spillway on the WS end. [Additional Reference(s): DWR Levee Log, 1992 (HLM 0.26). USACE Sacramento O&M Manual, Unit 504, May 1965, Revised 2 February 2011, (HLM 0.26), listed as 24-inch pipe. USACE As-Built Drawing No. 50-04-3685, Sheet 41 table of drainage structures, STA 92+46, 19 May 1965].

Water-Side: Headwall and flap gate at levee toe

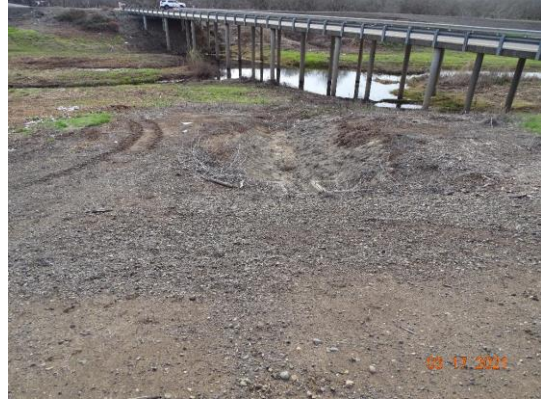
Photo 3 of 3 : UCIP_FA_2023_77889_99224.jpg

Water-Side: View of levee slope looking from crown

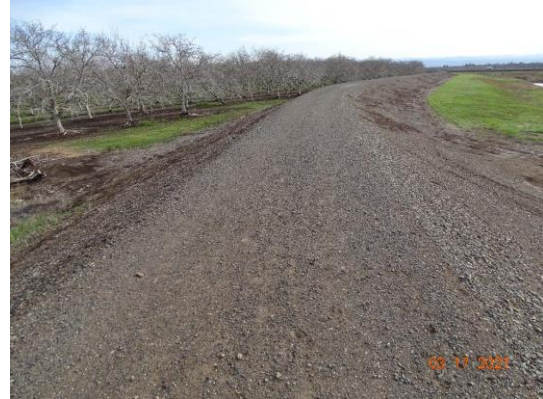
Photo 1 of 3 : UCIP_FA_2023_67238_99231.jpg

Comment Code						
Inspector Comment						
DS_ID:19211 FS_ID:67238 EP_NO: N/A Repair Type: No Action Needed EVAL Issue: Crossing Status: Found UCIP Comments: 09/15/2023 Record updated from Non-Urgent to No Action Needed. Pipe was CIPP lined. DMP internal video inspection has found none or minor pipe defects. Recommend next video inspection in 5 years. (O. Yakimov - DWR UCIP) 03/17/2021 Record remains Non-Urgent. Vegetation on waterside has been cleared. No permit has been identified authorizing pipe. DMP internal video inspection has found pipe integrity issues. LOF of crossing is greater than or equal to 4.1 and less than 5. Crossing will be monitored until funding becomes available for rehabilitation. (O.Yakimov - DWR UCIP) 02/20/2014 Vegetation debris on waterside. Needs clearing and cleaning. (P. Amatya - DWR UCIP) FIELD_STRUCT_DESC: 24-inch CIPP-lined corrugated metal gravity drainage pipe through the levee, 12 feet below the crown. Flap gate on the waterside (WS) end. Concrete U-shaped headwall on each end. Grouted riprap apron on the landside (LS) end. Grouted riprap spillway on the WS end. [Additional Reference(s): DWR Levee Log, 1992 (HLM 1.01). USACE Sacramento O&M Manual, Unit 504, May 1965, Revised 2 February 2011, (HLM 1.03), listed as 24-inch pipe. USACE As-Built Drawing No. 50-04-3685, Sheet 3, STA 132+00, 19 May 1965. USACE As-Built Drawing No. 50-04-3685, Sheet 41 table of drainage structures, STA 132+00, 19 May 1965]. FS Date: 3/17/2021

Top of Levee: View of levee crown looking upstream

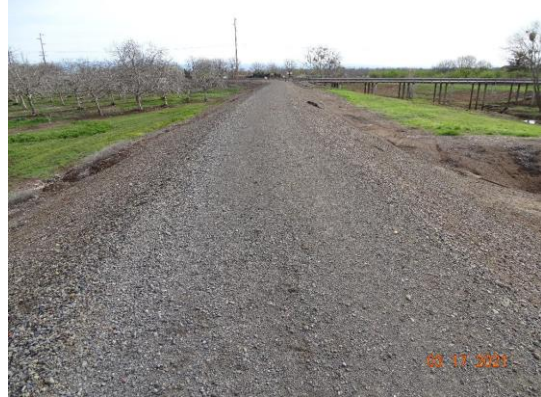
Photo 1 of 3 : UCIP_FA_2023_67239_99237.jpg

Comment Code						
Inspector Comment						
DS_ID:19212 FS_ID:67239 EP_NO: N/A Repair Type: Non-Urgent EVAL Issue: Crossing Status: Found UCIP Comments: 03/17/2021 Record updated from No Action Needed to Non-Urgent. No permit has been identified authorizing pipe. DMP internal video inspection has not found pipe integrity issues. LOF of crossing is less or equal to 4.0. Recommend next video inspection in 5 years. (O.Yakimov - DWR UCIP) 08/29/2016: Shawn Bates of NA0003 has cleared the LS and WS of debris and blockage; WS gate functions properly now. Crossing has been downgraded from Urgent to No Action Needed. (K. Fazel - UCIP) 08/11/2016: Same as last inspection. (K. Fazel - UCIP) 02/20/2014: No riprap spillway on waterside. Needs cleaning and clearing of debris. Flap gate was not fully closed. (P. Amatya - DWR UCIP) FIELD_STRUCT_DESC: 24-inch corrugated metal gravity drainage pipe through the levee, 13 feet below the crown. Flap gate on the waterside (WS) end. Concrete U-shaped headwall on each end. Grouted riprap apron on the landside (LS) end. Grouted riprap spillway on the WS end. [Additional Reference(s): DWR Levee Log, 1992 (HLM 1.90). USACE Sacramento O&M Manual, Unit 504, May 1965, Revised 2 February 2011, (HLM 1.95), listed as 24-inch pipe. USACE As-Built Drawing No. 50-04-3685, Sheet 4, STA 179+60, 19 May 1965. USACE As-Built Drawing No. 50-04-3685, Sheet 41 table of drainage structures, STA 179+60, 19 May 1965]. FS Date: 3/17/2021 9:01:17 AM

Top of Levee: View of levee crown looking upstream

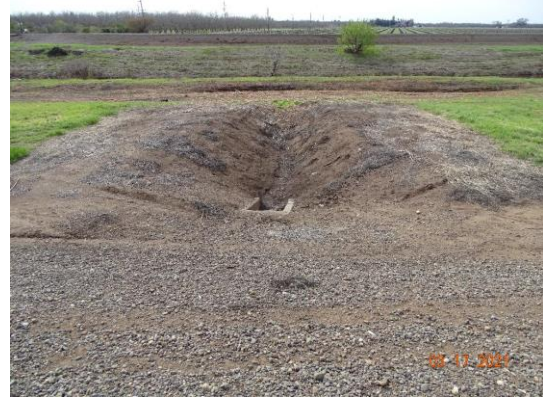
Photo 2 of 3 : UCIP_FA_2023_67239_99238.jpg

Water-Side: View of levee slope looking from crown

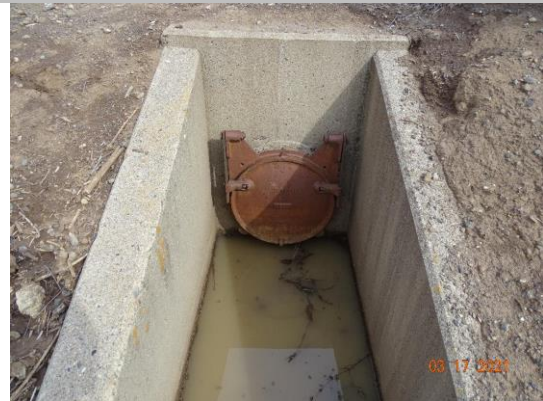
Photo 3 of 3 : UCIP_FA_2023_67239_99242.jpg

Water-Side: Headwall and flap gate at levee toe

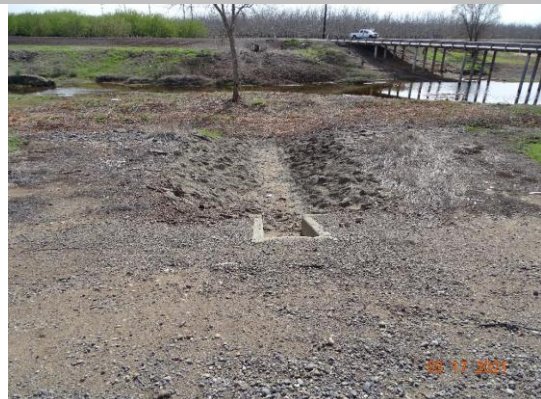
Photo 2 of 3 : UCIP_FA_2023_67246_99272.jpg

Comment Code						
Inspector Comment						
DS_ID:19216 FS_ID:67246 EP_NO: N/A Repair Type: Non-Urgent EVAL Issue: Crossing Status: Found UCIP Comments: 03/17/2021 Record remains Non-Urgent. No permit has been identified authorizing pipe. DMP internal video inspection has not found pipe integrity issues. LOF of crossing is less or equal to 4.0. Recommend next video inspection in 5 years. (O.Yakimov - DWR UCIP) 02/20/2014 Inlet and outlet needs cleaning and clearing of debris. (P. Amatya - DWR UCIP) FIELD_STRUCT_DESC: 24-inch corrugated metal gravity drainage pipe through the levee, 8.5 feet below the crown. Flap gate on the waterside (WS) end. Concrete U-shaped headwall on each end. Grouted riprap apron on the landside (LS) end. Grouted riprap spillway on the WS end. [Additional Reference(s): DWR Levee Log, 1992 (HLM 3.11). USACE Sacramento O&M Manual, Unit 504, May 1965, Revised 2 February 2011, (HLM 3.11), listed as 24-inch pipe. USACE As-Built Drawing No. 50-04-3685, Sheet 5, STA 239+60, 19 May 1965. USACE As-Built Drawing No. 50-04-3685, Sheet 41 table of drainage structures, STA 239+60, 19 May 1965]. FS Date: 3/17/2021 10:06:03 AM

Water-Side: View of levee slope looking from crown

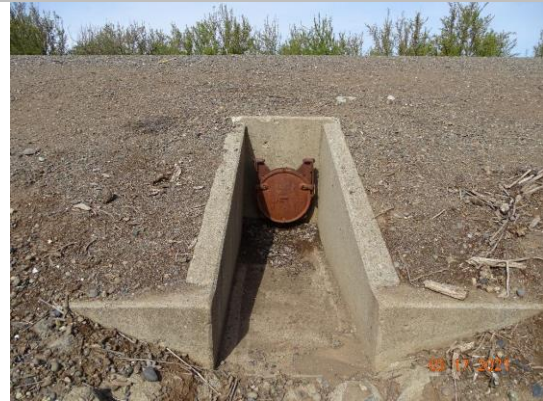
Photo 3 of 3 : UCIP_FA_2023_67246_99273.jpg

Water-Side: Headwall and flap gate at levee toe

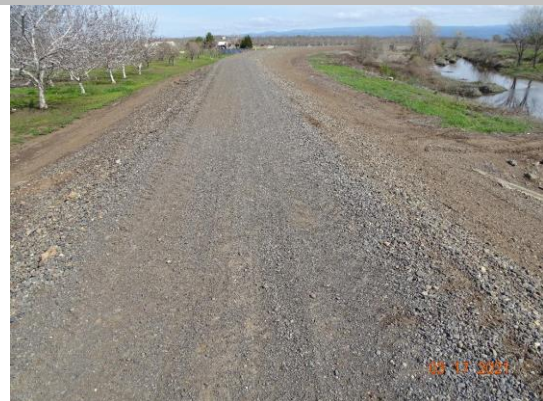
Photo 1 of 3 : UCIP_FA_2023_67247_99276.jpg

DS_ID:19217
 FS_ID:67247
 EP_NO: N/A
 Repair Type: Non-Urgent
 EVAL Issue:
 Crossing Status: Found
 UCIP Comments: 03/17/2021 Record remains Non-Urgent. No permit has been identified authorizing pipe. DMP internal video inspection has not found pipe integrity issues. LOF of crossing is less or equal to 4.0. Recommend next video inspection in 5 years. Debris has been cleared. (O.Yakimov - DWR UCIP)
 02/20/2014 It needs cleaning and clearing in inlet and outlet ends. (P. Amatya - DWR UCIP)
 FIELD_STRUCT_DESC: 24-inch corrugated metal gravity drainage pipe through the levee, 9 feet below the crown. Flap gate on the waterside (WS) end. Concrete U-shaped headwall on each end. Grouted riprap apron on the landside (LS) end. Grouted riprap spillway on the WS end.
 [Additional Reference(s): DWR Levee Log, 1992 (HLM 3.27). USACE Sacramento O&M Manual, Unit 504, May 1965, Revised 2 February 2011, (HLM 3.27), listed as 24-inch pipe. USACE As-Built Drawing No. 50-04-3685, Sheet 5, STA 247+60, 19 May 1965. USACE As-Built Drawing No. 50-04-3685, Sheet 41 table of drainage structures, STA 247+60, 19 May 1965].

Top of Levee: View of levee crown looking upstream

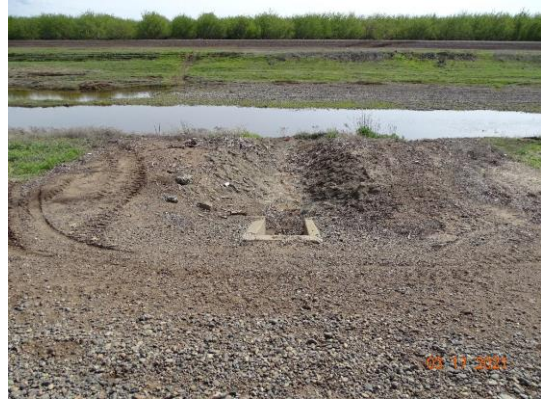
Photo 2 of 3 : UCIP_FA_2023_67247_99277.jpg

Water-Side: View of levee slope looking from crown

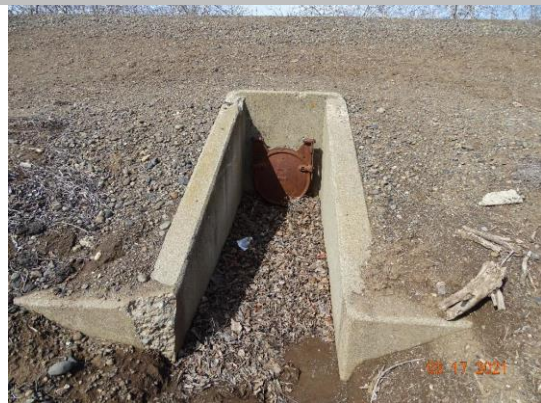
Photo 3 of 3 : UCIP_FA_2023_67247_99281.jpg

Water-Side: Headwall and flap gate at levee toe

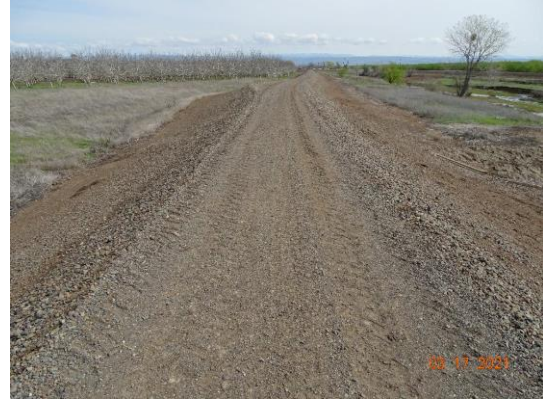
Photo 1 of 3 : UCIP_FA_2023_67248_99282.jpg

Comment Code					
Inspector Comment					
DS_ID:19218 FS_ID:67248 EP_NO: N/A Repair Type: Non-Urgent EVAL Issue: Crossing Status: Found UCIP Comments: 03/17/2021 Record remains Non-Urgent. No permit has been identified authorizing pipe. DMP internal video inspection has not found pipe integrity issues. LOF of crossing is less or equal to 4.0. Recommend next video inspection in 5 years. (O.Yakimov - DWR UCIP) 02/20/2014 Needs cleaning and clearing of debris. (P. Amatya - DWR UCIP) FIELD_STRUCT_DESC: 24-inch corrugated metal gravity drainage pipe through the levee, 10 feet below the crown. Flap gate on the waterside (WS) end. Concrete U-shaped headwall on each end. Grouted riprap apron on the landside (LS) end. Grouted riprap spillway on the WS end. [Additional Reference(s): DWR Levee Log, 1992 (HLM 3.48). USACE Sacramento O&M Manual, Unit 504, May 1965, Revised 2 February 2011, (HLM 3.48), listed as 24-inch pipe. USACE As-Built Drawing No. 50-04-3685, Sheet 5, STA 258+70, 19 May 1965. USACE As-Built Drawing No. 50-04-3685, Sheet 41 table of drainage structures, STA 258+70, 19 May 1965]. FS Date: 3/17/2021 10:18:14 AM

Top of Levee: View of levee crown looking upstream

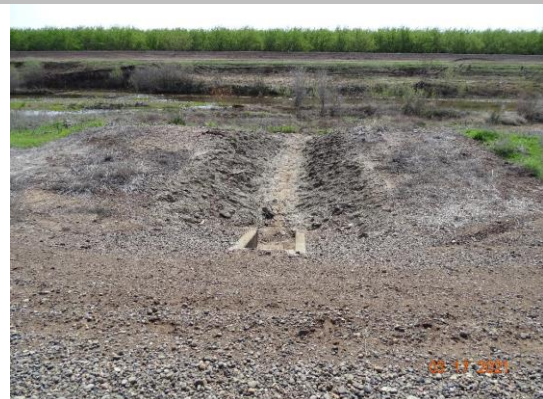
Photo 2 of 3 : UCIP_FA_2023_67248_99283.jpg

Water-Side: View of levee slope looking from crown

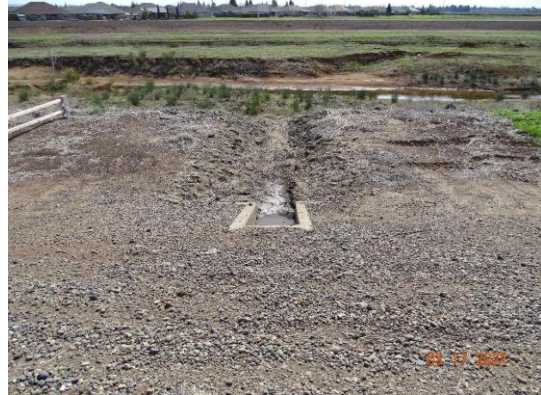
Photo 2 of 3 : UCIP_FA_2023_67249_99289.jpg

DS_ID:19219
FS_ID:67249
EP_NO: N/A
Repair Type: Non-Urgent
EVAL Issue:
Crossing Status: Found
UCIP Comments: 03/17/2021 Record remains Non-Urgent. No permit has been identified authorizing pipe. DMP internal video inspection has not found pipe integrity issues. LOF of crossing is less or equal to 4.0. Recommend next video inspection in 5 years. (O.Yakimov - DWR UCIP)
02/20/2014 Needs cleaning and clearing of debris in both ends of the pipe. (P. Amatya - DWR UCIP)
FIELD_STRUCT_DESC: 24-inch corrugated metal gravity drainage pipe through the levee, 9 feet below the crown. Flap gate on the waterside (WS) end. Concrete U-shaped headwall on each end. Grouted riprap apron on the landside (LS) end. Grouted riprap spillway on the WS end. [Additional Reference(s): DWR Levee Log, 1992 (HLM 4.08). USACE Sacramento O&M Manual, Unit 504, May 1965, Revised 2 February 2011, (HLM 4.08), listed as 24-inch pipe. USACE As-Built Drawing No. 50-04-3685, Sheet 41 table of drainage structures, STA 289+20, 19 May 1965].

Water-Side: View of levee slope looking from crown

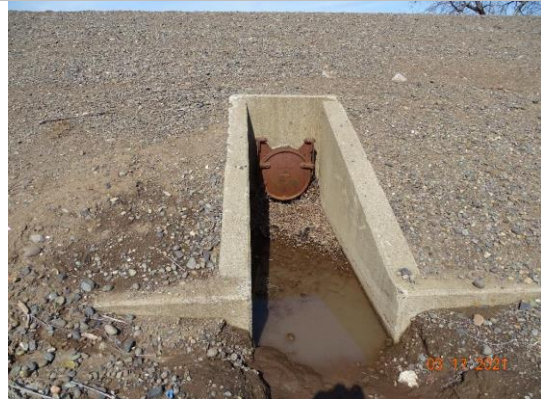
Photo 3 of 3 : UCIP_FA_2023_67249_99293.jpg

Water-Side: Headwall and flap gate at levee toe

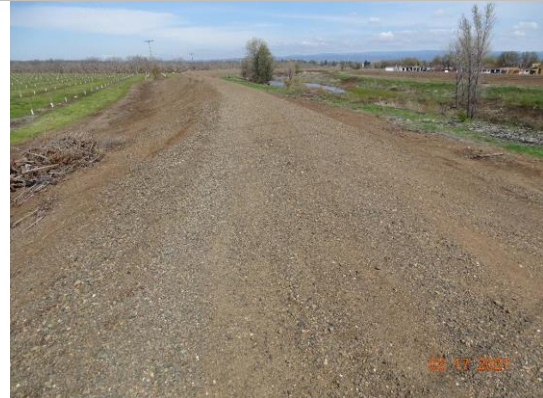
Photo 1 of 3 : UCIP_FA_2023_67250_99294.jpg

Comment Code					
Inspector Comment					
DS_ID:19220 FS_ID:67250 EP_NO: N/A Repair Type: Non-Urgent EVAL Issue: Crossing Status: Found UCIP Comments: 03/17/2021 Record remains Non-Urgent. Debris has been cleared. No permit has been identified authorizing pipe. DMP internal video inspection has not found pipe integrity issues. LOF of crossing is less or equal to 4.0. Recommend next video inspection in 5 years. (O.Yakimov - DWR UCIP) 02/20/2014 Needs cleaning and clearing of debris. (P. Amatya - DWR UCIP) FIELD_STRUCT_DESC: 24-inch corrugated metal gravity drainage pipe through the levee, 13 feet below the crown. Flap gate on the waterside (WS) end. Concrete U-shaped headwall on each end. Grouted riprap apron on the landside (LS) end. Grouted riprap spillway on the WS end. [Additional Reference(s): DWR Levee Log, 1992 (HLM 4.57). USACE Sacramento O&M Manual, Unit 504, May 1965, Revised 2 February 2011, (HLM 4.58), listed as 24-inch pipe. USACE As-Built Drawing No. 50-04-3685, Sheet 6, STA 315+18, 19 May 1965]. FS Date: 3/17/2021 10:24:31 AM

Top of Levee: View of levee crown looking upstream

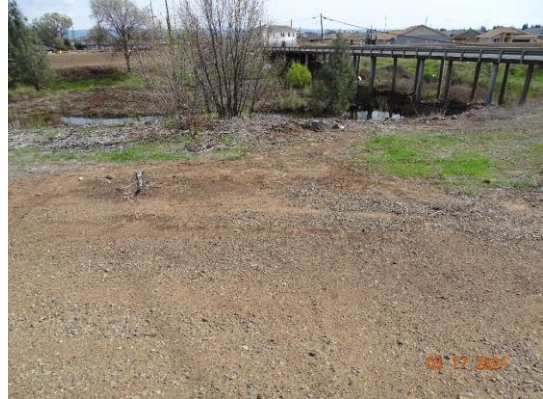
Photo 2 of 3 : UCIP_FA_2023_67250_99296.jpg

Water-Side: View of levee slope looking from crown

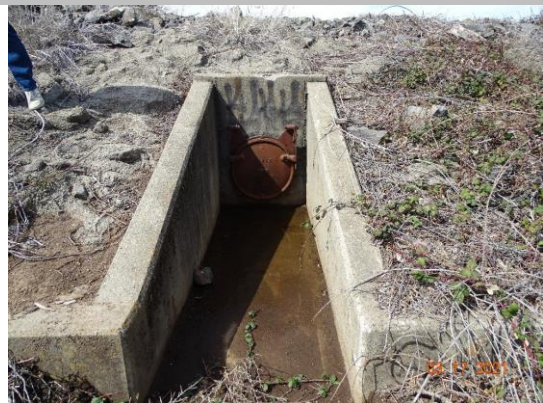
Photo 3 of 3 : UCIP_FA_2023_67250_99299.jpg

Water-Side: Headwall and flap gate on levee slope

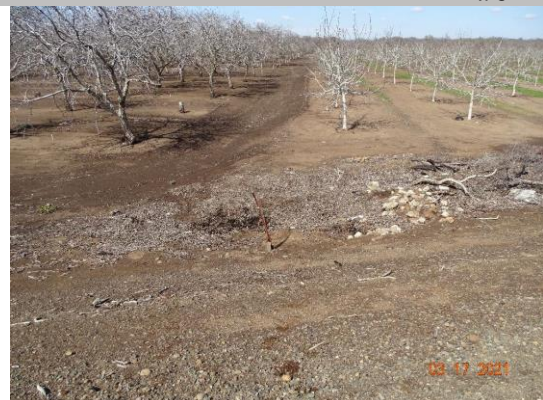
Photo 2 of 3 : UCIP_FA_2023_67251_99303.jpg

Comment Code						
Inspector Comment						
DS_ID:19221 FS_ID:67251 EP_NO: N/A Repair Type: Urgent EVAL Issue: 1, Pipe Integrity Crossing Status: Found UCIP Comments: 03/17/2021 Record updated from Non-Urgent to Urgent. DMP internal video inspection has found pipe integrity issues. LOF of crossing is between 5 and 6. Crossing will be monitored until funding becomes available to address the issues. Flap gate on waterside pipe end is non-operating. Recommend lubricating hinges for easy opening. Drainage inlet at landside toe is buried in soil - unable to locate. Crossing appears abandoned. No permit has been identified authorizing pipe. (O.Yakimov - DWR UCIP) 02/20/2014 CM Standpipe intake. Intake pipe with air vent. Steel rib-bar grit cover on the standpipe on landside levee toe.Needs cleaning and clearing on both ends of the pip. (P. Amatya - DWR UCIP). FIELD_STRUCT_DESC: 24-inch corrugated metal gravity drainage pipe through the levee, 15 feet below the crown. Flap gate on the waterside (WS) end. Concrete U-shaped headwall on the WS end. Grouted riprap spillway on the WS end. Corrugated metal standpipe intake. Intake pipe with an air vent. Steel rib-bar grit cover on the standpipe on the landside (LS) toe. [Additional Reference(s): DWR Levee Log, 1992 (HLM 4.93). USACE Sacramento O&M Manual, Unit 504, May 1965, Revised 2 February 2011, (HLM 4.94), listed as 24-inch pipe. USACE As-Built Drawing No. 50-04-3685, Sheet 6, STA 333+70, 19 May 1965]. FS Date: 3/17/2021 10:28:36 AM

Land-Side: View of levee slope looking from crown

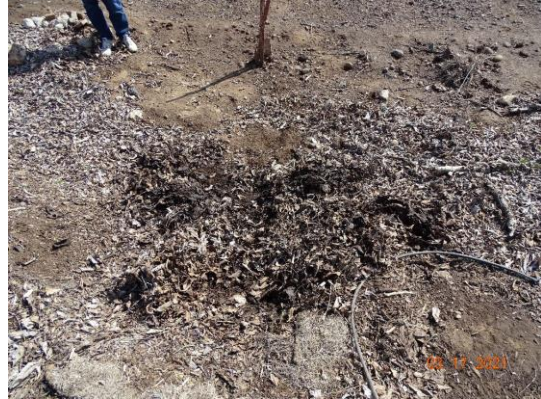
Photo 3 of 3 : UCIP_FA_2023_67251_99302.jpg

Land-Side: Approximate location on pipe inlet at levee toe, although inlet was not found

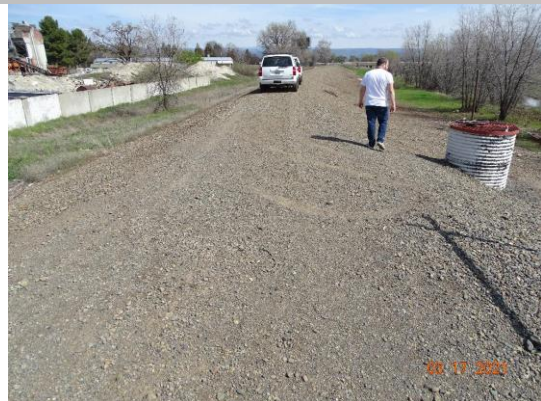
Photo 1 of 3 : UCIP_FA_2023_67286_99399.jpg

DS_ID:19222
 FS_ID:67286
 EP_NO: N/A
 Repair Type: Non-Urgent
 EVAL Issue:
 Crossing Status: Found
 UCIP Comments: 03/17/2021 Record updated from No Action Needed to Non-Urgent. No permit has been identified authorizing pipe. DMP internal video inspection has not found pipe integrity issues. LOF of crossing is less or equal to 4.0. Recommend next video inspection in 5 years. (O.Yakimov - DWR UCIP)
 02/20/2014 Slide gate in CM stadpipe on waterside levee slope. (P. Amatya - DWR UCIP)
 FIELD_STRUCT_DESC: 36-inch corrugated metal gravity drainage pipe through the levee, 17 feet below the crown. Slide gate in a corrugated metal standpipe on the waterside (WS) slope. Flap gate on the WS end. Concrete U-shaped headwall on each end. Grouted riprap apron on the landside (LS) end. Grouted riprap spillway on the WS end. [Additional Reference(s): DWR Levee Log, 1992 (HLM 5.22). USACE Sacramento O&M Manual, Unit 504, May 1965, Revised 2 February 2011, (HLM 5.22), listed as 36-inch pipe. USACE As-Built Drawing No. 50-04-3685, Sheet 7, from STA 348+25 to STA 352+50, 19 May 1965].

Top of Levee: View of levee crown looking upstream

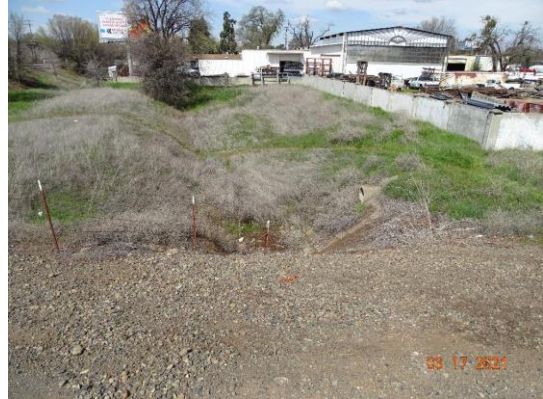
Photo 2 of 3 : UCIP_FA_2023_67286_99400.jpg

Land-Side: View of levee slope looking from crown. Drainage ditch on landside

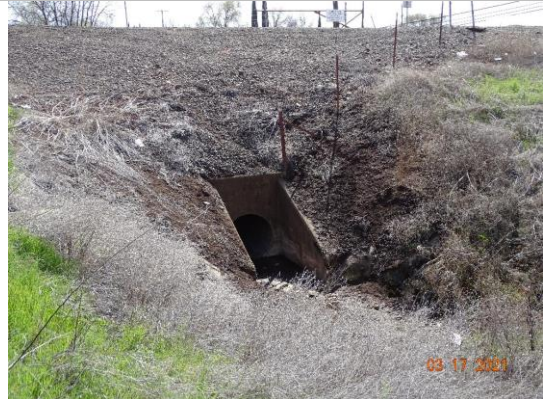
Photo 3 of 3 : UCIP_FA_2023_67286_99404.jpg

Land-Side: Headwall and pipe inlet in drainage ditch at levee toe

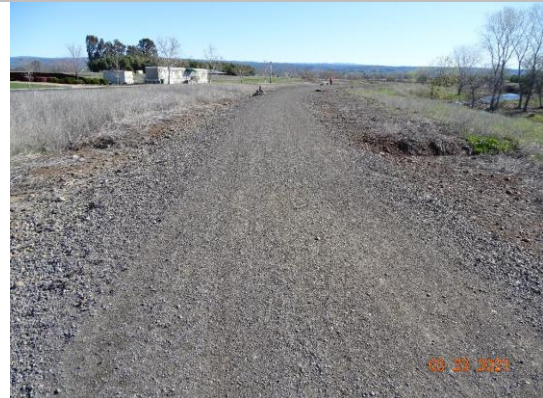
Photo 1 of 3 : UCIP_FA_2023_67292_99434.jpg

Top of Levee: View of levee crown looking upstream

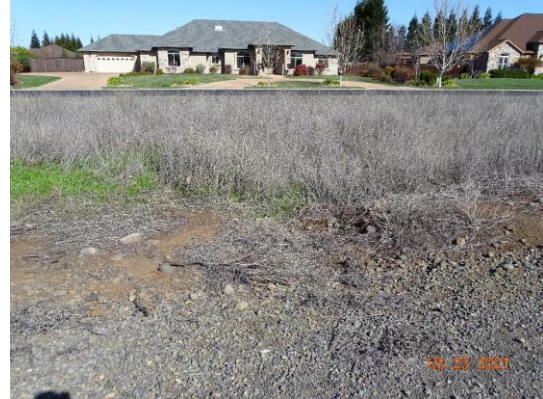
Photo 3 of 3 : UCIP_FA_2023_67292_99436.jpg

Land-Side: View of levee slope looking from crown

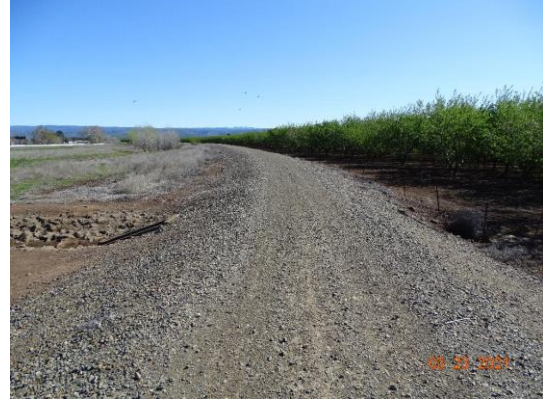
Photo 1 of 3 : UCIP_FA_2023_67304_99515.jpg

Top of Levee: View of levee crown looking upstream

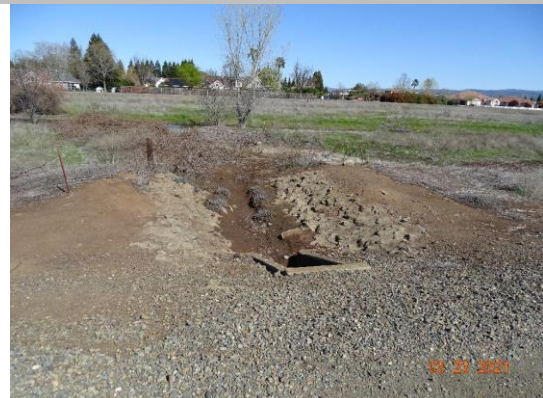
Photo 2 of 3 : UCIP_FA_2023_67304_99516.jpg

Water-Side: View of levee slope looking from crown

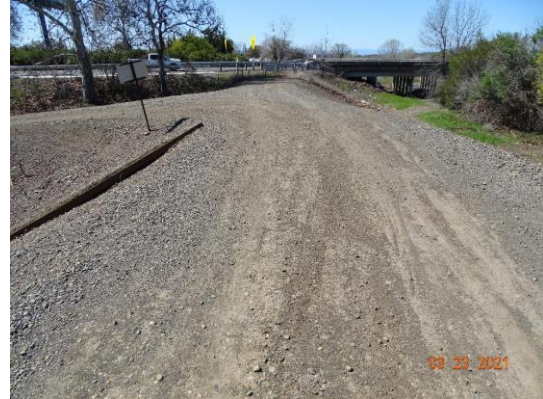
Photo 1 of 3 : UCIP_FA_2023_77890_99521.jpg

Top of Levee: View of levee crown looking downstream

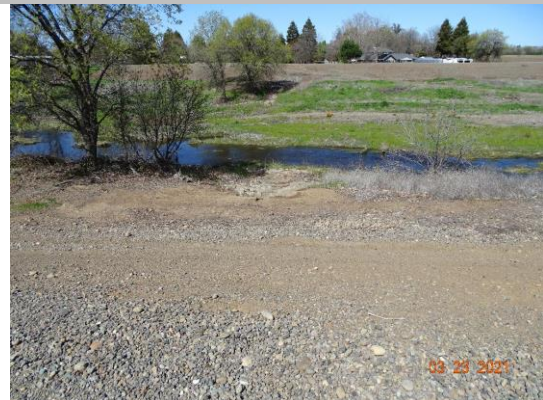
Photo 2 of 3 : UCIP_FA_2023_77890_99522.jpg

Water-Side: View of levee slope looking from crown

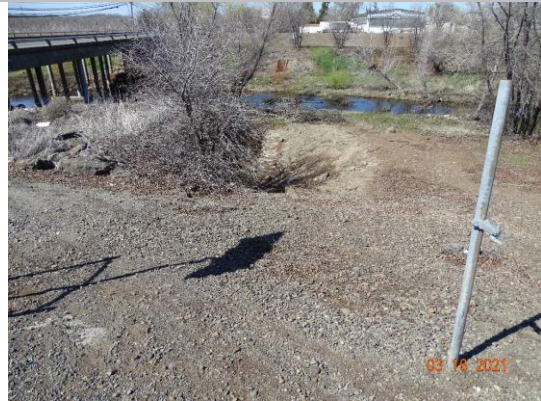
Photo 2 of 3 : UCIP_FA_2023_67308_99540.jpg

Water-Side: View of levee slope looking from crown

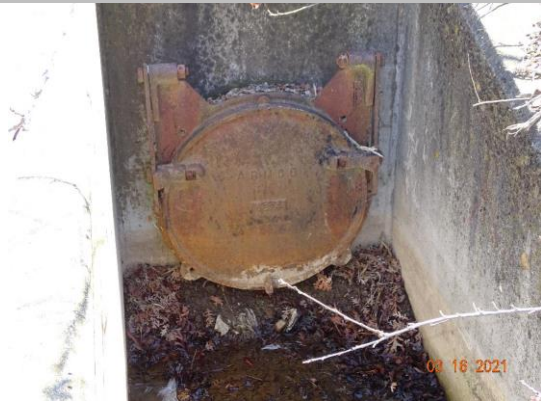
Photo 3 of 3 : UCIP_FA_2023_67308_99544.jpg

Water-Side: Headwall and flap gate at levee toe

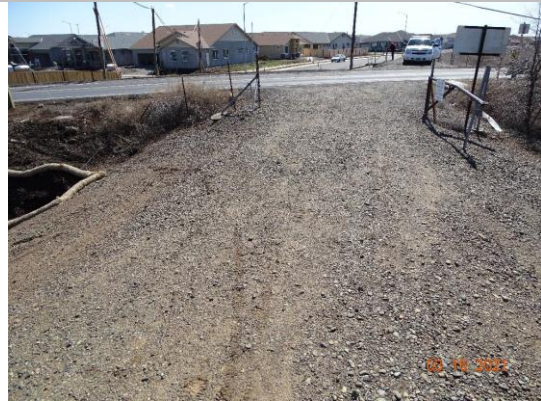
Photo 1 of 3 : UCIP_FA_2023_67339_99728.jpg

Top of Levee: View of levee crown looking downstream

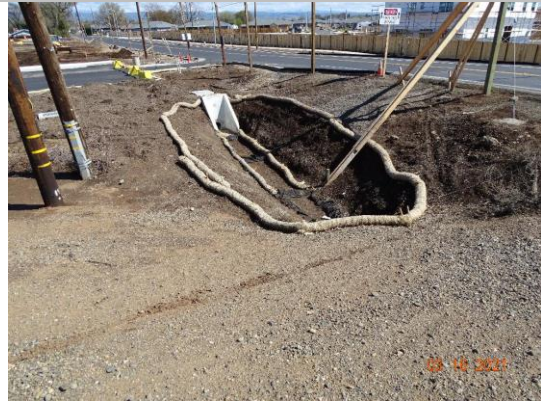
Photo 2 of 3 : UCIP_FA_2023_67339_99729.jpg

Land-Side: View of levee slope looking from crown. Newly constructed drainage on the berm

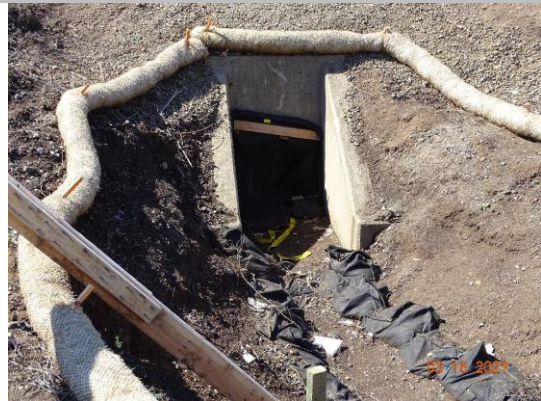
Photo 3 of 3 : UCIP_FA_2023_67339_99733.jpg

Land-Side: U-shaped headwall and covered pipe inlet at levee toe

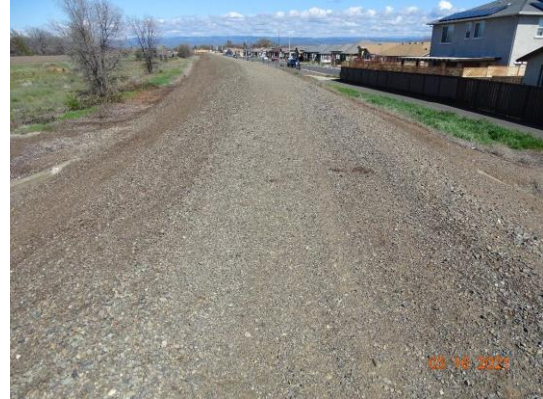
Photo 1 of 3 : UCIP_FA_2023_67340_99744.jpg

Top of Levee: View of levee crown looking upstream

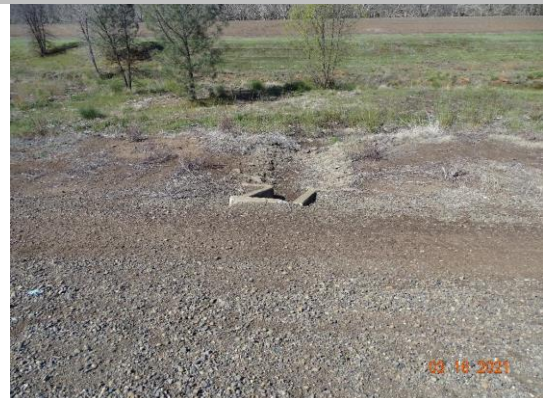
Photo 2 of 3 : UCIP_FA_2023_67340_99746.jpg

Water-Side: View of levee slope looking from crown

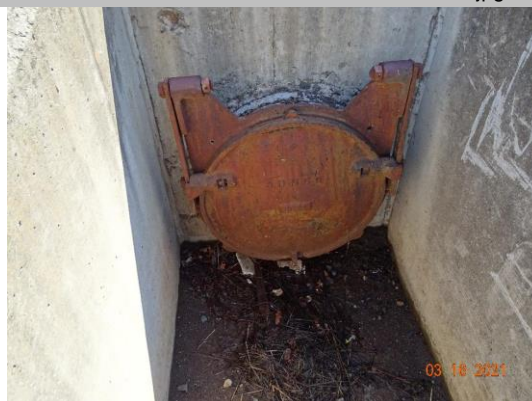
Photo 3 of 3 : UCIP_FA_2023_67340_99747.jpg

Water-Side: Headwall and flap gate at levee toe

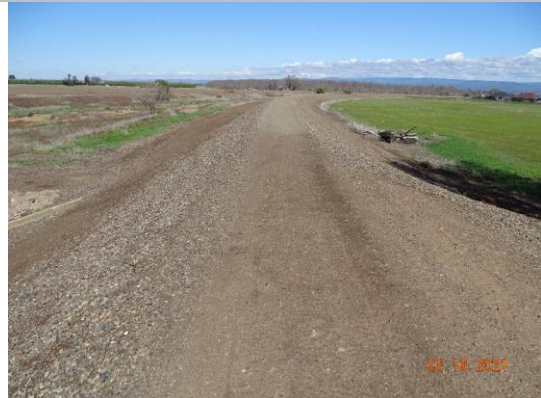
Photo 1 of 3 : UCIP_FA_2023_67341_99750.jpg

Top of Levee: View of levee crown looking upstream

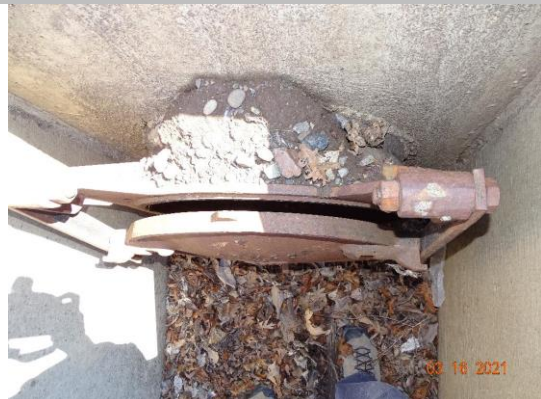
Photo 2 of 3 : UCIP_FA_2023_67341_99755.jpg

Comment Code					
Inspector Comment					
DS_ID:19240 FS_ID:67341 EP_NO: N/A Repair Type: Urgent EVAL Issue: 3a, Flood Risk Crossing Status: Found UCIP Comments: 03/16/2021 Record updated from Non-Urgent to Urgent. Flap gate not closing complitely. A gap between flap gate and pipe is visible. Adjustments and lubrication to flap gate hinges need to be done. DMP internal video inspection has not found pipe integrity issues. LOF of crossing is less or equal to 4. Recommend next video inspection in 5 years. (O.Yakimov - DWR UCIP) 02/24/2014 Needs cleaning and clearing of debris. (P. Amatya - DWR UCIP) FIELD_STRUCT_DESC: 24-inch corrugated metal gravity drainage pipe through the levee, 10 feet below the crown. Flap gate on the waterside (WS) end. Concrete U-shaped headwall on each end. Grouted riprap apron on the landside (LS) end. Grouted riprap spillway on the WS end. [Additional Reference(s): DWR Levee Log, 1992 (HLM 2.84). USACE Sacramento O&M Manual, Unit 504, May 1965, Revised 2 February 2011, (HLM 2.86), listed as 24-inch pipe. USACE As-Built Drawing No. 50-04-3685, Sheets 6 and 41, STA 280+00, 19 May 1965]. FS Date: 3/16/2021 12:43:55 PM

Water-Side: Gap visible between flap gate and pipe. Flap gate is unable to close tightly

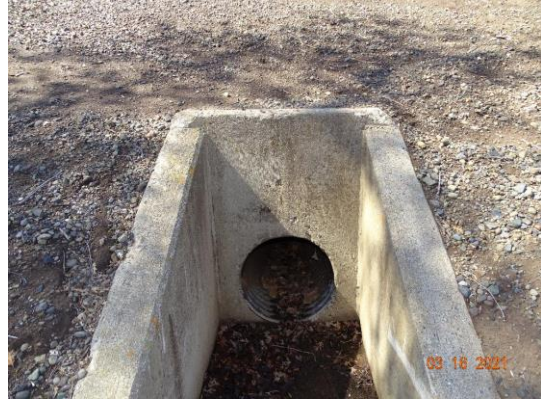
Photo 3 of 3 : UCIP_FA_2023_67341_99753.jpg

Land-Side: U-shaped headwall and pipe at levee toe

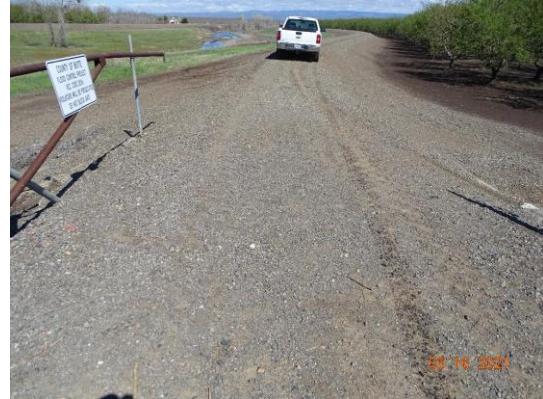
Photo 1 of 3 : UCIP_FA_2023_67342_99757.jpg

Top of Levee: View of levee crown looking upstream

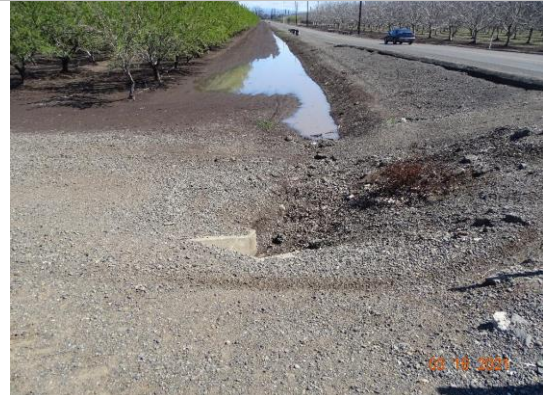
Photo 2 of 3 : UCIP_FA_2023_67342_99758.jpg

Land-Side: View of levee slope looking from crown

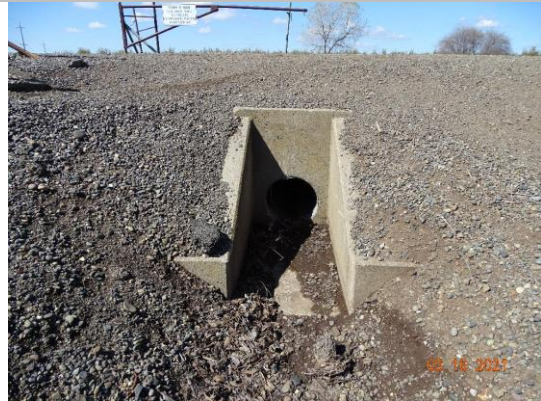
Photo 3 of 3 : UCIP_FA_2023_67342_99761.jpg

Land-Side: U-shaped headwall and pipe at levee toe

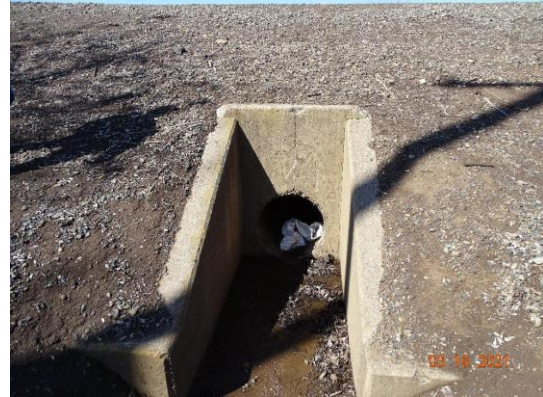
Photo 3 of 3 : UCIP_FA_2023_67347_99784.jpg

Land-Side: U-shaped headwall and pipe at levee toe

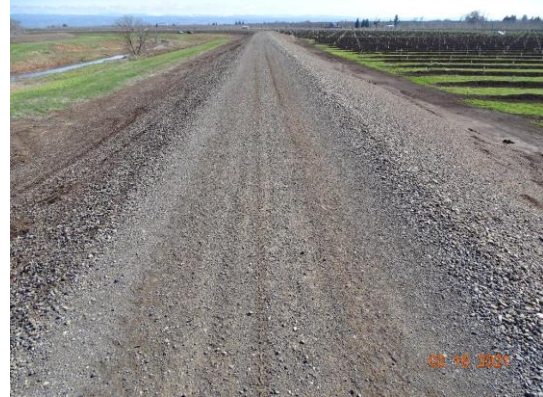
Photo 1 of 3 : UCIP_FA_2023_77891_99792.jpg

Top of Levee: View of levee crown looking upstream

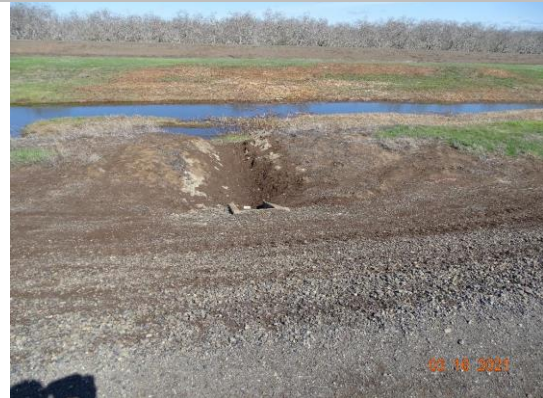
Photo 2 of 3 : UCIP_FA_2023_77891_99793.jpg

Water-Side: View of levee slope looking from crown

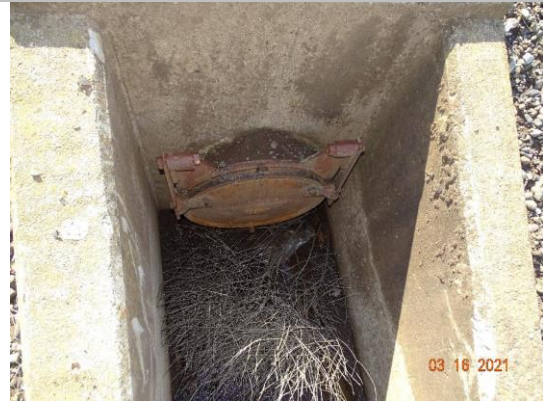
Photo 3 of 3 : UCIP_FA_2023_77891_99795.jpg

Comment Code						
Inspector Comment						
DS_ID:19247						
FS_ID:77891						
EP_NO: N/A						
Repair Type: Non-Urgent						
EVAL Issue:						
Crossing Status: Found						
UCIP Comments: 12/19/2022 Record updated from Urgent to Non-Urgent. Pipe has been CIPP-lined. LOF of crossing is less or equal to 4. Recommend next video inspection in 5 years. (O.Yakimov - DWR UCIP)						
03/16/2021 Record updated from Non-Urgent to Urgent. DMP internal video inspection has found pipe integrity issues. LOF of crossing is between 5 and 6. Crossing will be monitored until funding becomes available to address the issues. No permit has been identified authorizing pipe. Sediment at bottom of CMP is still present. (O.Yakimov - DWR UCIP)						
02/25/2014 Needs cleaning and clearing of debris. (P. Amatya - DWR UCIP)						
FIELD_STRUCT_DESC: 24-inch CIPP-lined corrugated metal gravity drainage pipe through the levee, 11.5 feet below the crown. Flap gate on the waterside (WS) end. Concrete U-shaped headwall on each end. Grouted riprap apron on the landside (LS) end. Grouted riprap spillway on the WS end. [Additional Reference(s): DWR Levee Log, 1992 (HLM 5.83). USACE Sacramento O&M Manual, Unit 504, May 1965, Revised 2 February 2011, (HLM 5.83), listed as 24-inch pipe. USACE As-Built Drawing No. 50-04-3685, Sheets 3 and 41, STA 134+60, 19 May 1965]. FS Date: 3/16/2021 3:59:32 PM

Water-Side: Headwall and flap gate at levee toe

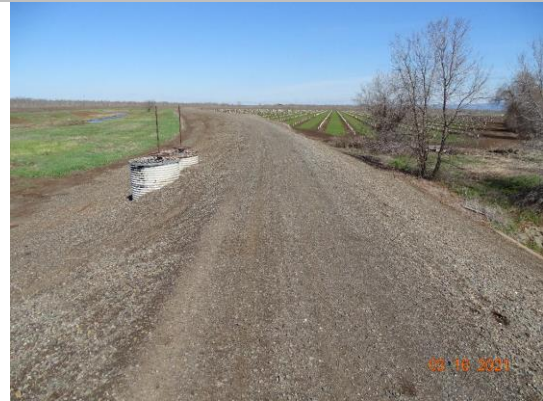
Photo 1 of 3 : UCIP_FA_2023_67351_99802.jpg

Comment Code						
Inspector Comment						
DS_ID:19248 FS_ID:67351 EP_NO: N/A Repair Type: No Action Needed EVAL Issue: Crossing Status: Found UCIP Comments: 09/15/2023 Record updated from Non-Urgent to No Action Needed. Pipe was CIPP lined. DMP internal video inspection has found none or minor pipe defects. Recommend next video inspection in 5 years. (O. Yakimov - DWR UCIP) 03/16/2021 Record remains Non-Urgent. DMP internal video inspection has found pipe integrity issues. LOF of crossing is between 4.1 and 5. Crossing will be monitored until funding becomes available for rehabilitation. No permit has been identified authorizing pipe. Debris has been cleared. (O.Yakimov - DWR UCIP) 02/25/2014 Needs cleaning and clearing of debris. (P. Amatya - DWR UCIP) FIELD_STRUCT_DESC: [Channel Slough Drainage Structure] 1 of 2: 42-inch CIPP-lined corrugated metal gravity drainage pipe through the levee, 16 feet below the crown. Flap gate on the waterside (WS) end. Slide gate in a corrugated metal pipe (CMP) riser on the WS slope. Concrete U-shaped headwall on each end. Grouted riprap apron and rock revetment on the landside (LS) end. [Additional Reference(s): DWR Levee Log, 1992 (HLM 6.30). USACE Sacramento O&M Manual, Unit 504, May 1965, Revised 2 February 2011, (HLM 6.30), listed as 42-inch pipe]. FS Date: 3/16/2021 11:45:20 AM

Top of Levee: View of levee crown looking upstream

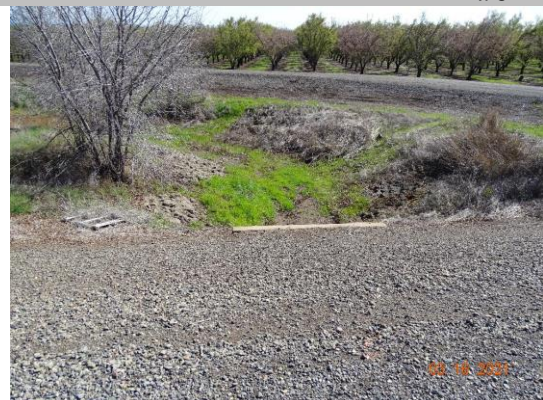
Photo 2 of 3 : UCIP_FA_2023_67351_99800.jpg

Land-Side: View of levee slope looking from crown

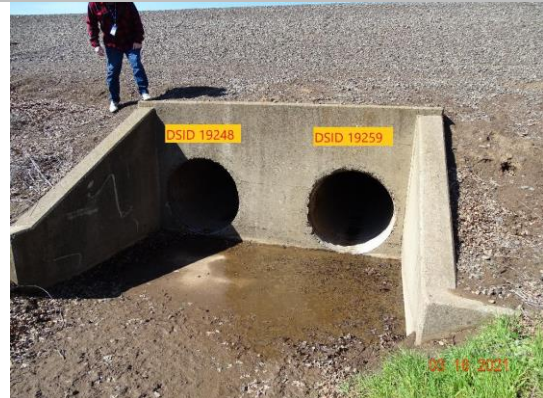
Photo 3 of 3 : UCIP_FA_2023_67352_99807.jpg

Comment Code						
Inspector Comment						
DS_ID:19259 FS_ID:67352 EP_NO: N/A Repair Type: No Action Needed EVAL Issue: Crossing Status: Found UCIP Comments: 09/15/2023 Record updated from Non-Urgent to No Action Needed. Pipe was CIPP lined. DMP internal video inspection has found none or minor pipe defects. Recommend next video inspection in 5 years. (O. Yakimov - DWR UCIP) 03/16/2021 Record remains Non-Urgent. No permit has been identified authorizing pipe. Debris has been cleared. DMP internal video inspection has found pipe integrity issues. LOF of crossing is greater than or equal to 4.1 and less than 5. Crossing will be monitored until funding becomes available for rehabilitation. (O.Yakimov - DWR UCIP) 02/25/2014 Needs cleaning and clearing of debris. (P. Amatya - DWR UCIP) FIELD_STRUCT_DESC: [Channel Slough Drainage Structure] 2 of 2: 42-inch CIPP-lined corrugated metal gravity drainage pipe through the levee, 16 feet below the crown. Flap gate on the waterside (WS) end. Slide gate in a corrugated metal pipe (CMP) riser on the WS slope. Concrete U-shaped headwall on each end. Grouted riprap apron and rock revetment on the landside (LS) end. [Additional Reference(s): DWR Levee Log, 1992 (HLM 6.30). USACE Sacramento O&M Manual, Unit 504, May 1965, Revised 2 February 2011, (HLM 6.30), listed as 42-inch pipe]. FS Date: 3/16/2021 11:47:02 AM

Land-Side: U-shaped headwall and pipe at levee toe

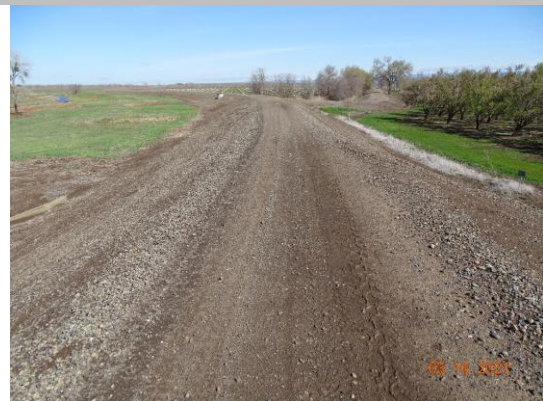
Photo 1 of 3 : UCIP_FA_2023_67353_99809.jpg

DS_ID:19249
FS_ID:67353
EP_NO: N/A
Repair Type: Urgent
EVAL Issue: 1, Pipe Integrity
Crossing Status: Found
UCIP Comments: 03/16/2021 Record updated from Non-Urgent to Urgent. DMP internal video inspection has found pipe integrity issues. LOF of crossing is between 5 and 6. Crossing will be monitored until funding becomes available to address the issues. No permit has been identified authorizing pipe. Debris has been cleared. (O.Yakimov - DWR UCIP)
02/25/2014 Needs cleaning and clearing of debris. (P. Amatya - DWR UCIP)
FIELD_STRUCT_DESC: 24-inch corrugated metal gravity drainage pipe through the levee, 12 feet below the crown. Flap gate on the waterside (WS) end. Concrete U-shaped headwall on each end. Grouted riprap apron on the landside (LS) end. Grouted riprap spillway on the WS end. [Additional Reference(s): DWR Levee Log, 1992 (HLM 6.35). USACE Sacramento O&M Manual, Unit 504, May 1965, Revised 2 February 2011, (HLM 6.35), listed as 24-inch pipe. USACE As-Built Drawing No. 50-04-3685, Sheets 3 and 41, STA 107+10, 19 May 1965].

Top of Levee: View of levee crown looking upstream

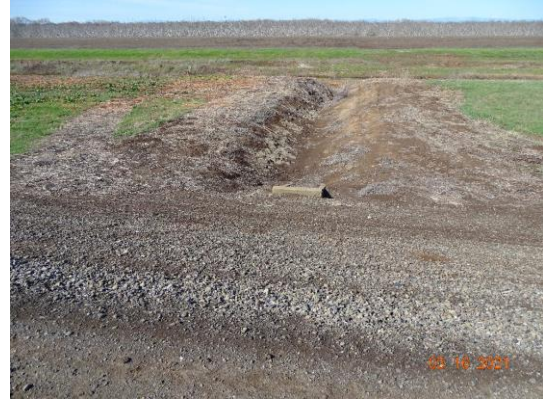
Photo 2 of 3 : UCIP_FA_2023_67353_99810.jpg

Water-Side: View of levee slope looking from crown

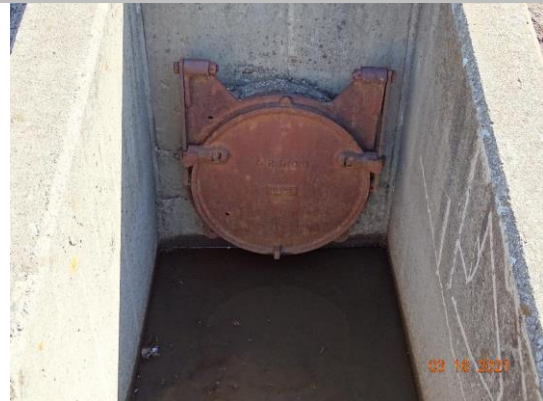
Photo 3 of 3 : UCIP_FA_2023_67353_99814.jpg

Water-Side: Headwall and flap gate at levee toe

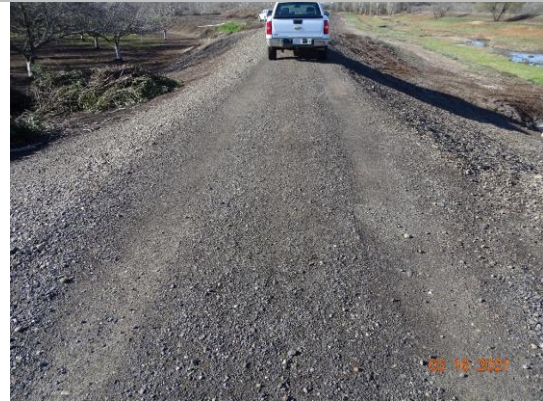
Photo 1 of 3 : UCIP_FA_2023_77892_99827.jpg

Comment Code						
Inspector Comment						
DS_ID:19251 FS_ID:77892 EP_NO: N/A Repair Type: Non-Urgent EVAL Issue: Crossing Status: Found UCIP Comments: 12/19/2022 Record updated from Urgent to Non-Urgent. Pipe has been CIPP-lined. LOF of crossing is less or equal to 4. Recommend next video inspection in 5 years. (O.Yakimov - DWR UCIP) 03/16/2021 Record updated from Non-Urgent to Urgent. DMP internal video inspection has found pipe integrity issues. LOF of crossing is between 5 and 6. Crossing will be monitored until funding becomes available to address the issues. No permit has been identified authorizing pipe. Debris has been cleared. (O.Yakimov - DWR UCIP) 02/25/2014 Needs cleaning and clearing of debris. (P. Amatya - DWR UCIP) FIELD_STRUCT_DESC: 24-inch CIPP-lined corrugated metal gravity drainage pipe through the levee, 15.5 feet below the crown. Flap gate on the waterside (WS) end. Concrete U-shaped headwall on each end. Grouted riprap apron on the landside (LS) end. Grouted riprap spillway on the WS end. Pipe crossing levee at angle. [Additional Reference(s): DWR Levee Log, 1992 (HLM 6.65). USACE Sacramento O&M Manual, Unit 504, May 1965, Revised 2 February 2011, (HLM 6.65), listed as 24-inch pipe. USACE As-Built Drawing No. 50-04-3685, Sheet 41, STA 91+98, 19 May 1965]. FS Date: 3/16/2021 4:01:52 PM

Top of Levee: View of levee crown looking downstream

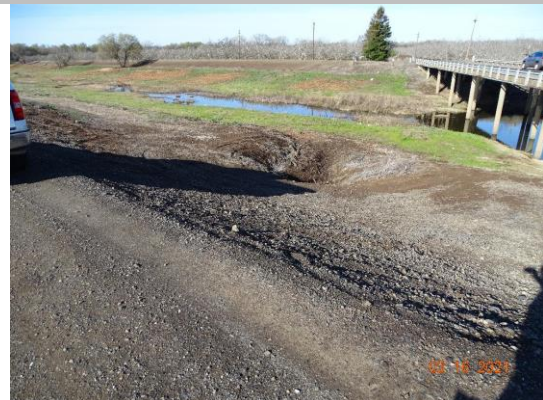
Photo 2 of 3 : UCIP_FA_2023_77892_99828.jpg

Water-Side: View of levee slope looking from crown

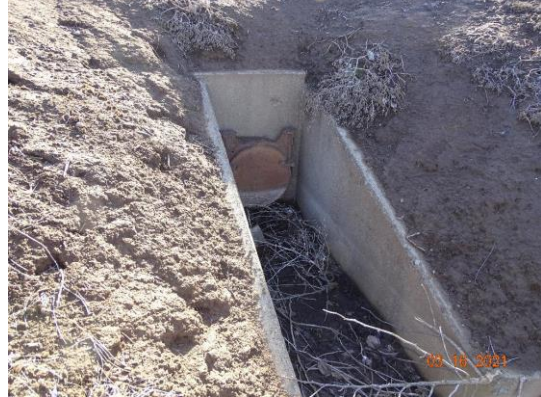
Photo 3 of 3 : UCIP_FA_2023_77892_99832.jpg

Water-Side: Headwall and flap gate at levee toe

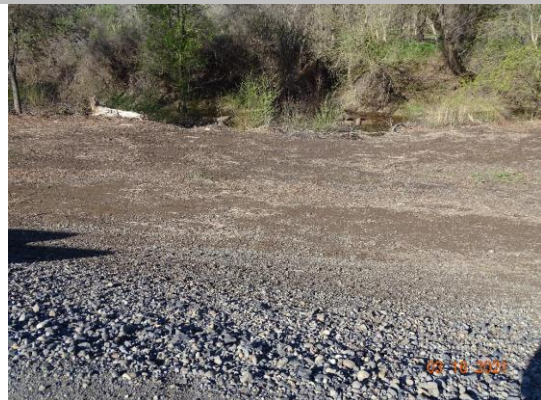
Photo 2 of 3 : UCIP_FA_2023_77893_99835.jpg

Water-Side: View of levee slope looking from crown

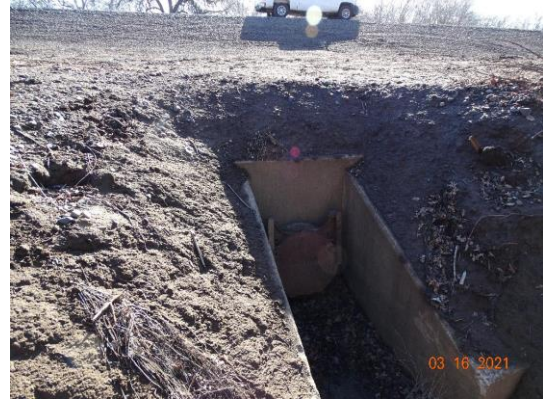
Photo 3 of 3 : UCIP_FA_2023_77893_99836.jpg

Water-Side: Headwall and flap gate on levee berm

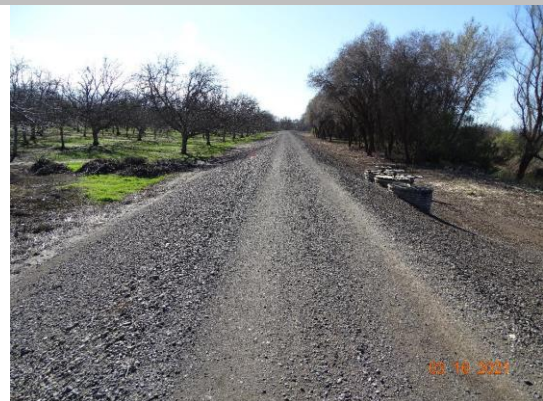
Photo 1 of 3 : UCIP_FA_2023_67359_99839.jpg

Top of Levee: View of levee crown looking downstream

DS_ID:19253
 FS_ID:67359
 EP_NO: N/A
 Repair Type: Non-Urgent
 EVAL Issue:
 Crossing Status: Found
 UCIP Comments: 03/16/2021 Record remains Non-Urgent. No permit has been identified authorizing pipe. Debris has been cleared. DMP internal video inspection has not found pipe integrity issues. LOF of crossing is less or equal to 4. Recommend next video inspection in 5 years. (O.Yakimov - DWR UCIP)
 02/25/2014 Slide gates in CMP risers on waterside shoulder. Needs cleaning and clearing of debris. (P. Amatya - DWR UCIP)
 FIELD_STRUCT_DESC: 1 of 3: 48-inch corrugated metal gravity drainage pipe through the levee, 18 feet below the crown. Flap gate on the waterside (WS) end. Slide gate in a corrugated metal pipe (CMP) riser on the WS shoulder. Concrete U-shaped headwall on each end. Grouted riprap apron on the landside (LS) end. Grouted riprap spillway on the WS end. [Additional Reference(s): DWR Levee Log, 1992 (HLM 7.46). USACE Sacramento O&M Manual, Unit 504, May 1965, Revised 2 February 2011, (HLM 7.46), listed as 48-inch pipe. USACE As-Built Drawing No. 50-04-3684, Sheets 3 and 6, STA 50+00, 15 April 1963].

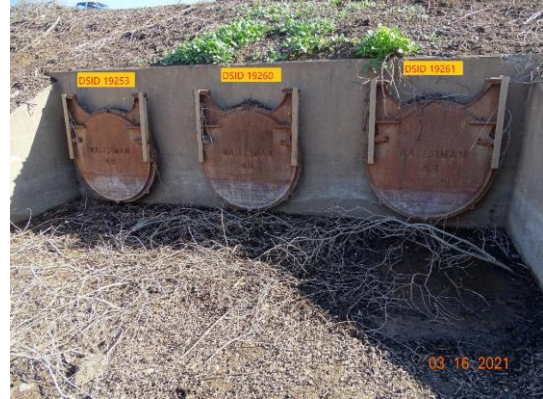
Photo 3 of 3 : UCIP_FA_2023_67361_99852.jpg

Water-Side: Headwall and flap gate at levee toe

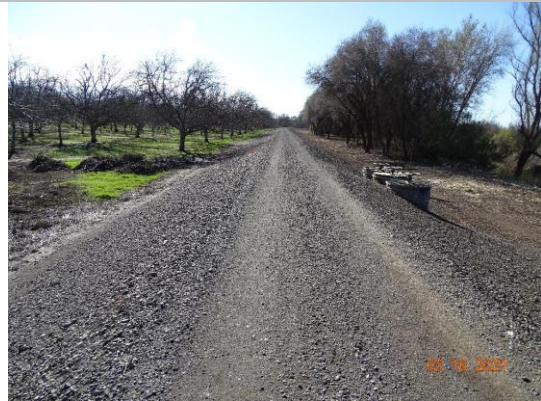
Photo 1 of 3 : UCIP_FA_2023_67360_99844.jpg

Comment Code						
Inspector Comment						
DS_ID:19260 FS_ID:67360 EP_NO: N/A Repair Type: No Action Needed EVAL Issue: Crossing Status: Found UCIP Comments: 09/15/2023 Record updated from Non-Urgent to No Action Needed. Pipe was CIPP lined. DMP internal video inspection has found none or minor pipe defects. Recommend next video inspection in 5 years. (O. Yakimov - DWR UCIP) 03/16/2021 Record remains Non-Urgent. DMP internal video inspection has found pipe integrity issues. LOF of crossing is greater than or equal to 4.1 and less than 5. Crossing will be monitored until funding becomes available for rehabilitation. No permit has been identified authorizing pipe. Debris has been cleared. (O.Yakimov - DWR UCIP) 02/25/2014 Slide gates in CMP risers on waterside shoulder. Needs cleaning and clearing of debris. (P. Amatya - DWR UCIP) FIELD_STRUCT_DESC: 2 of 3: 48-inch corrugated metal gravity drainage pipe through the levee, 18 feet below the crown. Flap gate on the waterside (WS) end. Slide gate in a corrugated metal pipe (CMP) riser on the WS shoulder. Concrete U-shaped headwall on each end. Grouted riprap apron on the landside (LS) end. Grouted riprap spillway on the WS end. [Additional Reference(s): DWR Levee Log, 1992 (HLM 7.46). USACE Sacramento O&M Manual, Unit 504, May 1965, Revised 2 February 2011, (HLM 7.46), listed as 48-inch pipe. USACE As-Built Drawing No. 50-04-3684, Sheets 3 and 6, STA 50+00, 15 April 1963]. FS Date: 3/16/2021 3:16:09 PM

Top of Levee: View of levee crown looking downstream

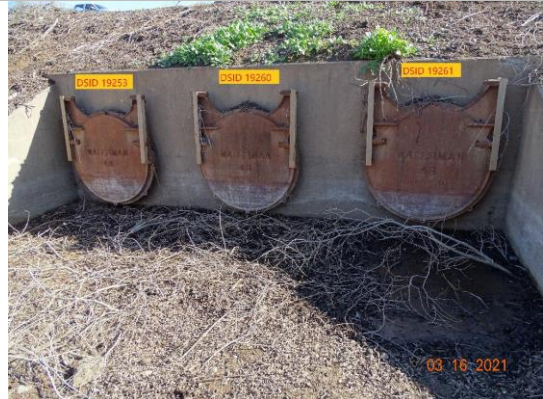
Photo 3 of 3 : UCIP_FA_2023_67360_99847.jpg

Water-Side: Headwall and flap gate at levee toe

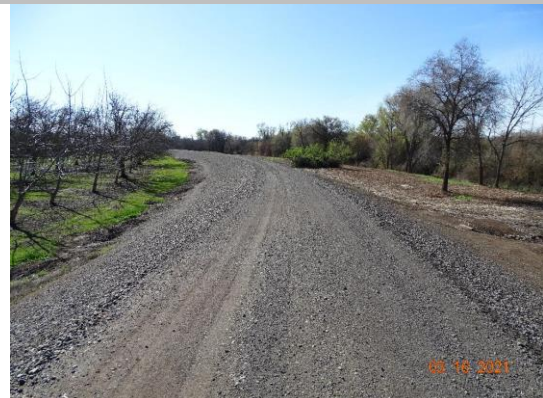
Photo 2 of 3 : UCIP_FA_2023_67362_99854.jpg

Top of Levee: View of levee crown looking downstream

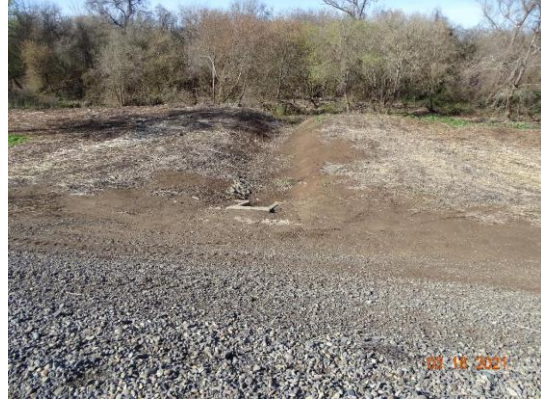
Photo 3 of 3 : UCIP_FA_2023_67362_99855.jpg

Water-Side: View of levee slope looking from crown
