**Flood Control Project Maintenance
Levee Inspections**

Maintenance Issue Types Only, Levee Inspection Report By Mile - Fall 2023

Butte County Department of Public Works

Waterway	Bank	Unit Miles	Inspection Start/End	Inspector
Unit No. 01 Mud Creek	Right	6.80	10/11/2023 10/11/2023	Makar Sokol

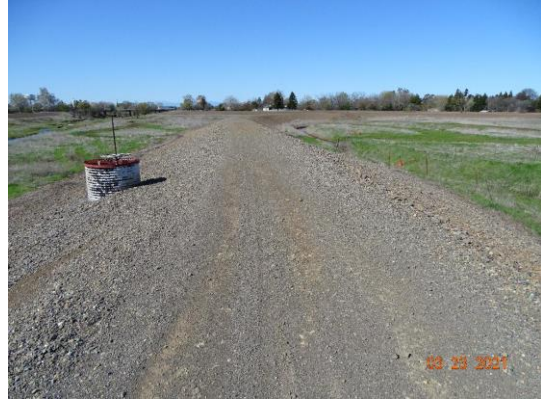
Photo 1 of 3 : UCIP_FA_2023_77894_100475.jpg

Comment Code					
Inspector Comment					
DS_ID:19262 FS_ID:77894 EP_NO: N/A Repair Type: Non-Urgent EVAL Issue: Crossing Status: Found UCIP Comments: 12/19/2022 Record updated from Urgent to Non-Urgent. Pipe has been CIPP-lined. LOF of crossing is less or equal to 4. Recommend next video inspection in 5 years. (O.Yakimov - DWR UCIP) 03/23/2021 Record updated from No Action Needed to Urgent. DMP internal video inspection has found pipe integrity issues. LOF of crossing is between 5 and 6. Crossing will be monitored until funding becomes available to address the issues. No permit has been identified authorizing pipe. (O.Yakimov - DWR UCIP) 05/16/2017 Crossing has been downgraded from Non-Urgent to No Action Needed. The flap gate appears to be in good working order based on the photos, and the small pile of debris not enough to warrant Non-Urgent rating. (K. Fazel - DWR UCIP) 03/11/2014 Slide gate in CMP riser on watersie. The culvert was working during field inspection. (P. Amatya - DWR) FIELD_STRUCT_DESC: 42-inch CIPP-lined corrugated metal gravity drainage pipe through the levee, 14 feet below the crown. Flap gate on the waterside (WS) end. Slide gate in a corrugated metal pipe (CMP) riser on the WS slope. Concrete U-shaped headwall on each end. Grouted riprap apron on the landside (LS) end. Grouted riprap spillway on the WS end. [Additional Reference(s): DWR Levee Log, 1992 (HLM 0.09). USACE Sacramento O&M Manual, Unit 504, May 1965, Revised 2 February 2011, (HLM 0.09), listed as 42-inch pipe. USACE As-Built Drawing No. 50-04-3685, Sheets 7 and 40, STA 370+60, 19 May 1965]. FS Date: 3/23/2021 4:04:43 PM

Top of Levee: View of levee crown looking downstream

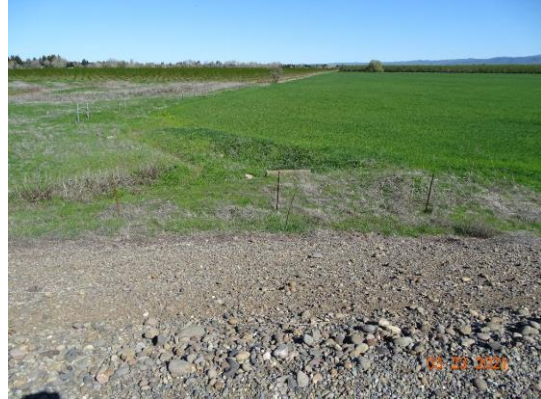
Photo 2 of 3 : UCIP_FA_2023_77894_100476.jpg

Land-Side: View of levee slope looking from crown

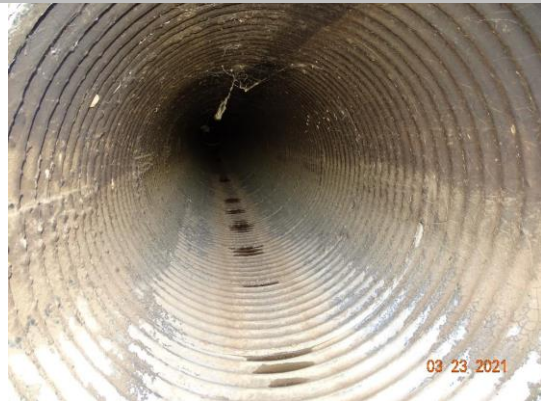
Photo 3 of 3 : UCIP_FA_2023_77894_100474.jpg

Land-Side: View inside of pipe looking from landside end

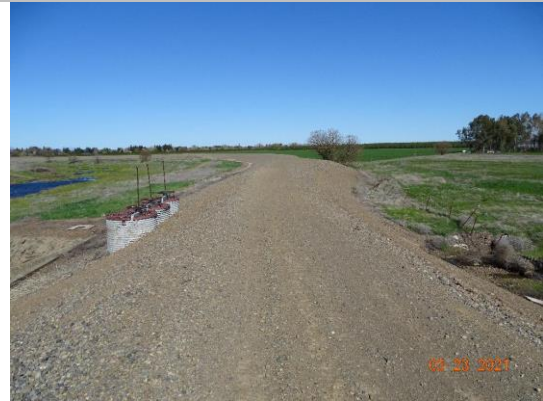
Photo 1 of 3 : UCIP_FA_2023_67669_100480.jpg

Comment Code					
Inspector Comment					
DS_ID:19278 FS_ID:67669 EP_NO: N/A Repair Type: Non-Urgent EVAL Issue: Crossing Status: Found UCIP Comments: 03/23/2021 Record updated from No Action Needed to Non-Urgent. No permit has been identified authorizing pipe. DMP internal video inspection has not found pipe integrity issues. LOF of crossing is less or equal to 4. Recommend next video inspection in 5 years. (O.Yakimov - DWR UCIP) 03/11/2014 Slide gate in CMP riser on waterside. The culvert was working during the field visit. (P. Amatya - DWR UCIP) FIELD_STRUCT_DESC: 1 of 3: 48-inch corrugated metal gravity drainage pipe through the levee, 11.7 feet below the crown. Slide gate in a riser well on the waterside (WS) slope. Concrete U-shaped headwall on each end. Flap gate on the WS end. Grouted riprap outlet channel on the WS. [Additional Reference(s): DWR Levee Log, 1992 (HLM 0.39). USACE Sacramento O&M Manual, Unit 504, May 1965, Revised 2 February 2011, (HLM 0.39), listed as 48-inch pipe. USACE As-Built Drawing No. 50-04-3685, Sheets 7 and 39, STA 385+90, 19 May 1965]. FS Date: 3/23/2021 2:00:15 PM

Top of Levee: View of levee crown looking downstream

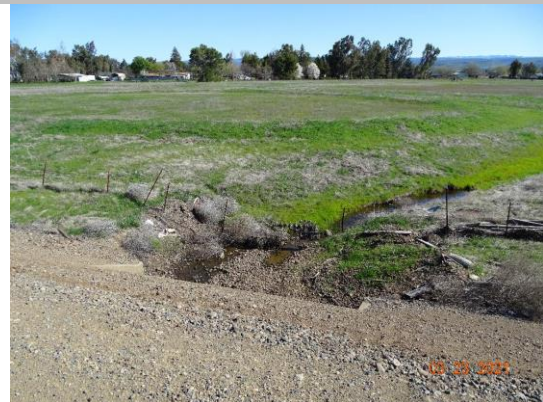
Photo 2 of 3 : UCIP_FA_2023_67669_100481.jpg

Land-Side: View of levee slope looking from crown

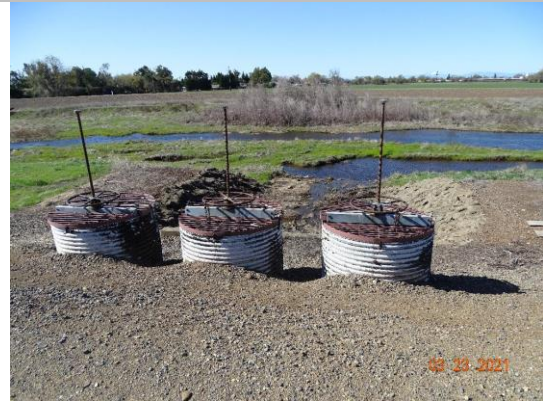
Photo 3 of 3 : UCIP_FA_2023_67669_100482.jpg

Water-Side: View of levee slope looking from crown. CMP riser with slide gate on levee shoulder

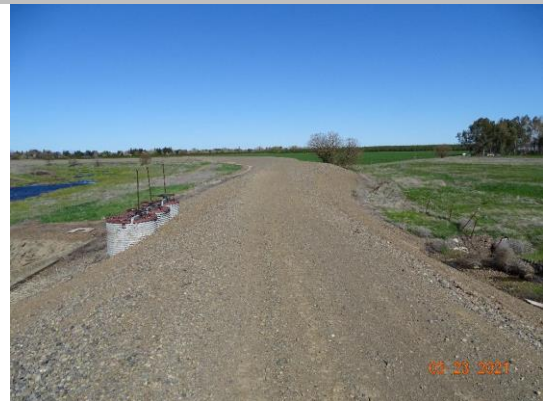
Photo 1 of 3 : UCIP_FA_2023_67670_100486.jpg

DS_ID:19277
FS_ID:67670
EP_NO: N/A
Repair Type: Non-Urgent
EVAL Issue:
Crossing Status: Found
UCIP Comments: 03/23/2021 Record updated from No Action Needed to Non-Urgent. No permit has been identified authorizing pipe. DMP internal video inspection has not found pipe integrity issues. LOF of crossing is less or equal to 4. Recommend next video inspection in 5 years. (O.Yakimov - DWR UCIP)
03/11/2014 Slide gate in CMP riser on waterside. The culvert was working during the field visit. (P. Amatya - DWR UCIP)
FIELD_STRUCT_DESC: 2 of 3: 48-inch corrugated metal gravity drainage pipe through the levee, 11.7 feet below the crown. Slide gate in a riser well on the waterside (WS) slope. Concrete U-shaped headwall on each end. Flap gate on the WS end. Grouted riprap outlet channel on the WS. [Additional Reference(s): DWR Levee Log, 1992 (HLM 0.39). USACE Sacramento O&M Manual, Unit 504, May 1965, Revised 2 February 2011, (HLM 0.39), listed as 48-inch pipe. USACE As-Built Drawing No. 50-04-3685, Sheets 7 and 39, STA 385+90, 19 May 1965].

Top of Levee: View of levee crown looking downstream

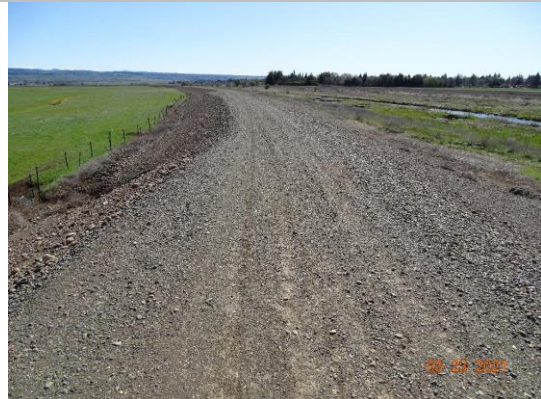
Photo 1 of 3 : UCIP_FA_2023_77895_100511.jpg

DS_ID:19264
 FS_ID:77895
 EP_NO: N/A
 Repair Type: Non-Urgent
 EVAL Issue:
 Crossing Status: Found
 UCIP Comments: 12/19/2022 Record updated from Urgent to Non-Urgent. Pipe has been CIPP-lined. LOF of crossing is less or equal to 4. Recommend next video inspection in 5 years. (O.Yakimov - DWR UCIP).
 03/23/2021 Record updated from No Action Needed to Urgent. DMP internal video inspection has found pipe integrity issues. LOF of crossing is between 5 and 6. Crossing will be monitored until funding becomes available to address the issues. No permit has been identified authorizing pipe. (O.Yakimov - DWR UCIP)
 03/11/2014 The culvert was working during the field visit. (P. Amatya - DWR UCIP)
 FIELD_STRUCT_DESC: 24-inch CIPP-lined corrugated metal gravity drainage pipe through the levee, 11.7 feet below the crown. Flap gate on the waterside (WS) end. Concrete U-shaped headwall on each end. [Additional Reference(s): DWR Levee Log, 1992 (HLM 1.26). USACE Sacramento O&M Manual, Unit 504, May 1965, Revised 2 February 2011, (HLM 1.28), listed as 24-inch pipe. USACE As-Built Drawing No. 50-04-3685, Sheet 9, STA 431+50, 19 May 1965].

Top of Levee: View of levee crown looking upstream

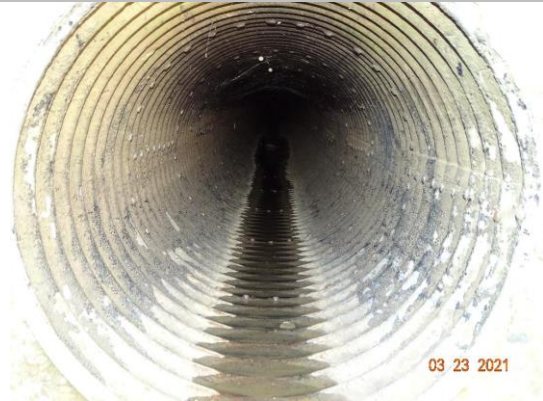
Photo 2 of 3 : UCIP_FA_2023_77895_100515.jpg

Land-Side: View inside of pipe looking from landside end

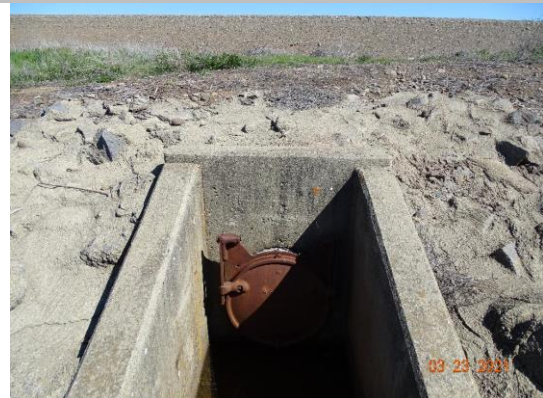
Photo 3 of 3 : UCIP_FA_2023_77895_100516.jpg

Water-Side: Headwall and flap gate at levee toe

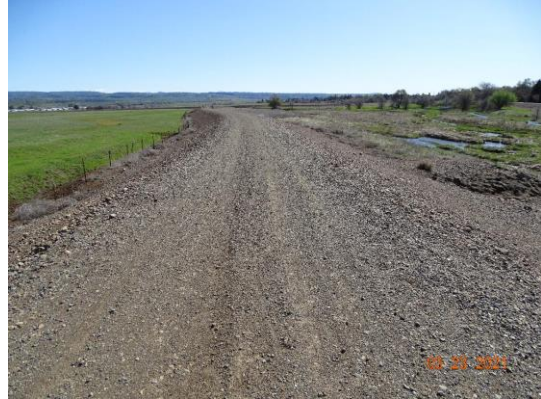
Photo 1 of 3 : UCIP_FA_2023_67677_100517.jpg

Comment Code						
Inspector Comment						
DS_ID:19265 FS_ID:67677 EP_NO: N/A Repair Type: No Action Needed EVAL Issue: Crossing Status: Found UCIP Comments: 09/15/2023 Record updated from Non-Urgent to No Action Needed. Pipe was CIPP lined. DMP internal video inspection has found none or minor pipe defects. Recommend next video inspection in 5 years. (O. Yakimov - DWR UCIP) 03/23/2021 Record updated from No Action Needed to Non-Urgent. DMP internal video inspection has found pipe integrity issues. LOF of crossing is greater than or equal to 4.1 and less than 5. Crossing will be monitored until funding becomes available for rehabilitation. No permit has been identified authorizing pipe. (O.Yakimov - DWR UCIP) 03/11/2014 Working during the field visit. (P. Amatya - DWR UCIP) FIELD_STRUCT_DESC: 24-inch CIPP-lined corrugated metal gravity drainage pipe through the levee, 11 feet below the crown. Flap gate on the waterside (WS) end. Concrete U-shaped headwall on each end. Grouted riprap apron on each end. [Additional Reference(s): DWR Levee Log, 1992 (HLM 1.52). USACE Sacramento O&M Manual, Unit 504, May 1965, Revised 2 February 2011, (HLM 1.53), listed as 24-inch pipe. USACE As-Built Drawing No. 50-04-3685, Sheet 9, STA 444+80, 19 May 1965]. FS Date: 3/23/2021 8:35:54 AM

Top of Levee: View of levee crown looking upstream

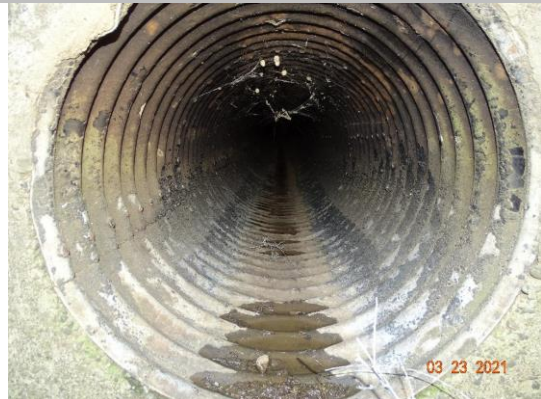
Photo 2 of 3 : UCIP_FA_2023_67677_100520.jpg

Land-Side: View inside of pipe looking from landside end

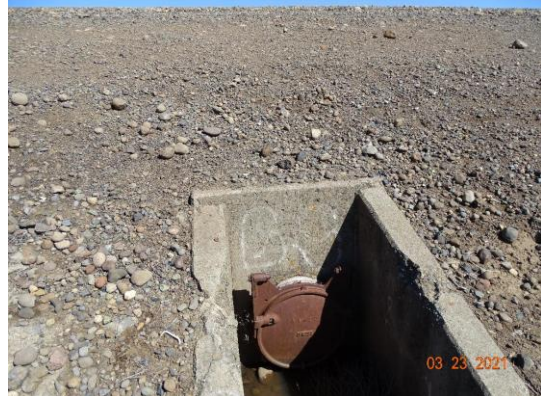
Photo 3 of 3 : UCIP_FA_2023_67677_100521.jpg

Water-Side: Levee slope, headwall and flap gate at levee toe

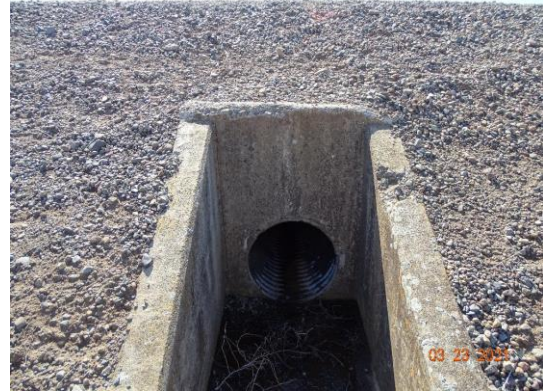
Photo 2 of 3 : UCIP_FA_2023_67678_100525.jpg

Land-Side: Levee slope, U-shaped headwall and pipe at levee toe

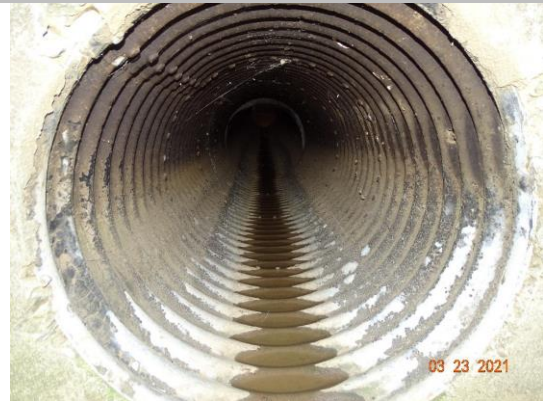
Photo 3 of 3 : UCIP_FA_2023_67678_100526.jpg

Land-Side: View inside of pipe looking from landside end

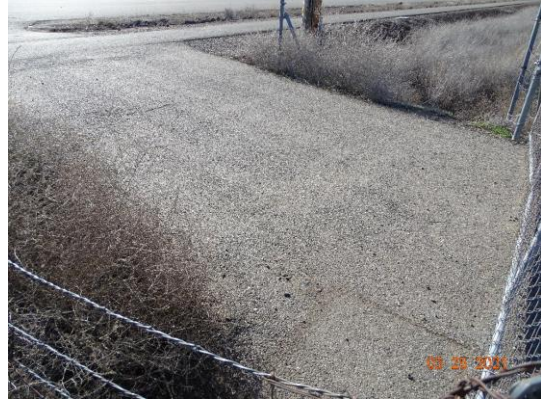
Photo 1 of 3 : UCIP_FA_2023_67679_100529.jpg

Comment Code						
Inspector Comment						
DS_ID:19267						
FS_ID:67679						
EP_NO: N/A						
Repair Type: Non-Urgent						
EVAL Issue:						
Crossing Status: Found						
UCIP Comments: 03/25/2021 Record remains Non-Urgent. No permit has been identified authorizing pipe. DMP internal video inspection has not found pipe integrity issues. LOF of crossing is less or equal to 4. Recommend next video inspection in 5 years. (O.Yakimov - DWR UCIP)						
03/07/2014 Pipe is about 4 feet below the crown. Needs cleaning and clearing the culvert. (P. Amatya - DWR UCIP)						
FIELD_STRUCT_DESC: 24-inch corrugated metal gravity drainage pipe through the levee, 6 feet below the crown. Flap gate on the waterside (WS) end. Concrete U-shaped headwall on each end. [Additional Reference(s): DWR Levee Log, 1992 (HLM 2.23). USACE Sacramento O&M Manual, Unit 504, May 1965, Revised 2 February 2011, (HLM 2.23), listed as 24-inch pipe. USACE As-Built Drawing No. 50-04-3685, Sheet 10, STA 46+90, 19 May 1965].

Top of Levee: View of levee crown looking upstream

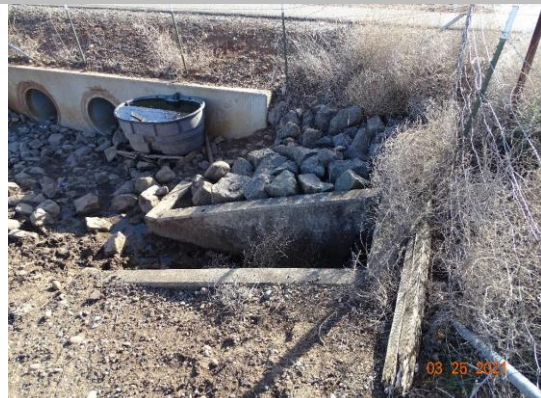
Photo 2 of 3 : UCIP_FA_2023_67679_100528.jpg

Water-Side: U-shaped Headwall and revetment on levee slope

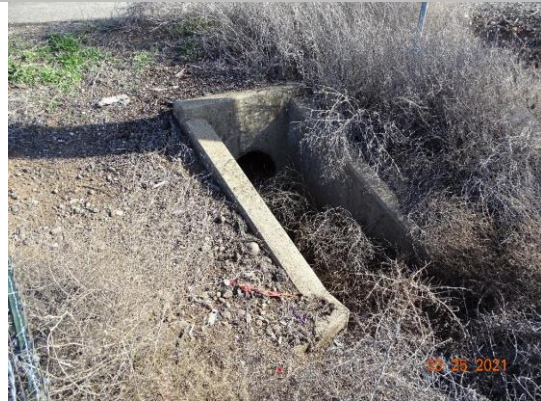
Photo 3 of 3 : UCIP_FA_2023_67679_100530.jpg

Land-Side: U-shaped headwall and pipe at levee toe

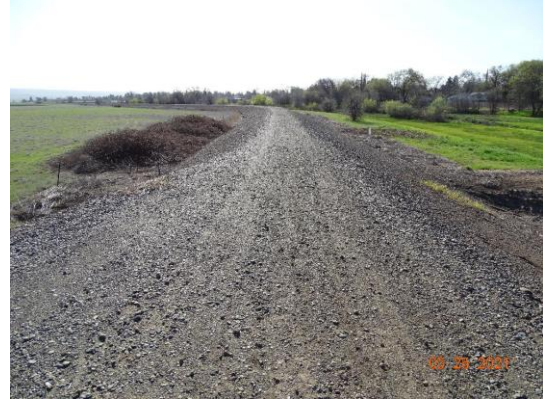
Photo 1 of 3 : UCIP_FA_2023_67681_100537.jpg

Comment Code						
Inspector Comment						
DS_ID:19269 FS_ID:67681 EP_NO: N/A Repair Type: Non-Urgent EVAL Issue: Crossing Status: Found UCIP Comments: 03/25/2021 Record remains Non-Urgent. No permit has been identified authorizing pipe. DMP internal video inspection has not found pipe integrity issues. LOF of crossing is less or equal to 4. Recommend next video inspection in 5 years. (O.Yakimov - DWR UCIP) 03/07/2021 Needs cleaning and clearing the culvert. (P. Amatya - DWR UCIP) FIELD_STRUCT_DESC: 24-inch corrugated metal gravity drainage pipe through the levee, 11 feet below the crown. Flap gate on the waterside (WS) end. Concrete U-shaped headwall on each end. Grouted riprap apron on the landside (LS) end. Grouted riprap spillway on the WS end. [Additional Reference(s): DWR Levee Log, 1992 (HLM 3.16). USACE Sacramento O&M Manual, Unit 504, May 1965, Revised 2 February 2011, (HLM 3.16), listed as 24-inch pipe]. FS Date: 3/25/2021 10:55:20 AM

Top of Levee: View of levee crown looking upstream

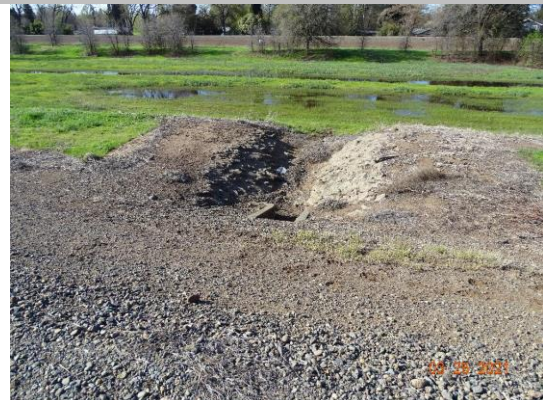
Photo 2 of 3 : UCIP_FA_2023_67681_100538.jpg

Water-Side: View of levee slope looking from crown

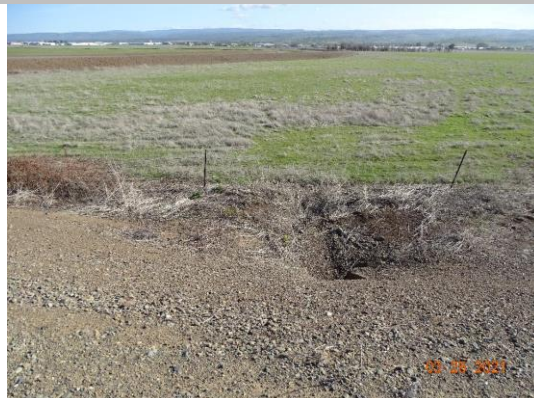
Photo 3 of 3 : UCIP_FA_2023_67681_100539.jpg

Land-Side: View of levee slope looking from crown

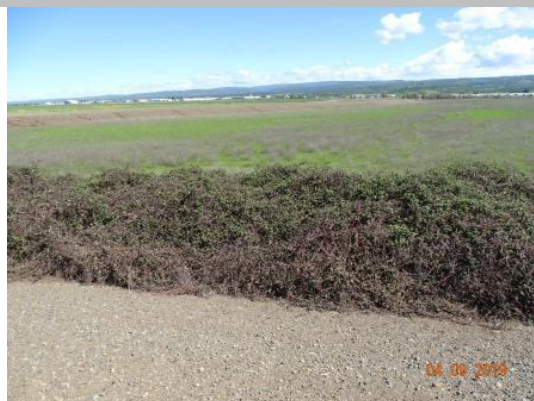
Photo 1 of 1 : FA_2023_NA0003_67_22_20231002_00003.jpg

View of the wild growth at the landside toe. Spring 2019.

LM Start	3.09	Rating **	M	Issue No.	22
LM End	3.09	Issue Type +	Ma	Location *	LS
Category	Earthen Levee			GPS Latitude/Longitude	
				Start	End
Item	Vegetation			39.777880°	39.777880°
				-121.854230°	-121.854230°
DWR ID	DWR_NA0003_03_s_2019_22				
Comment Code					
V2 : Remove the wild growth and woody vegetation other than native grasses from the levee slopes.					
Inspector Comment

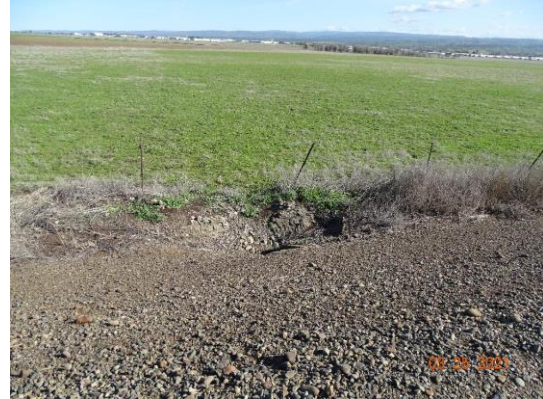
Photo 3 of 3 : UCIP_FA_2023_67682_100545.jpg

Land-Side: View of levee slope looking from crown

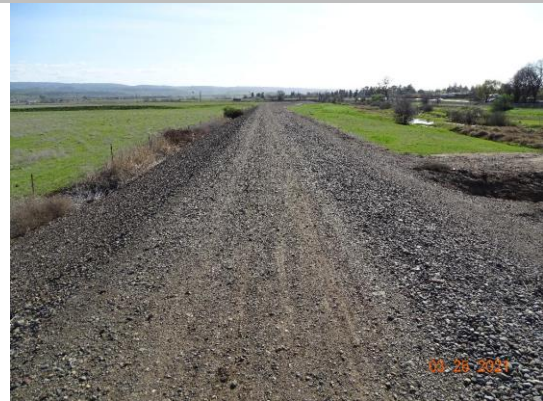
Photo 1 of 3 : UCIP_FA_2023_67683_100549.jpg

DS_ID:19271
 FS_ID:67683
 EP_NO: N/A
 Repair Type: Non-Urgent
 EVAL Issue:
 Crossing Status: Found
 UCIP Comments: 03/25/2021 Record remains Non-Urgent. Debris around culver has been cleared. No permit has been identified authorizing pipe. DMP internal video inspection has not found pipe integrity issues. LOF of crossing is less or equal to 4. Recommend next video inspection in 5 years. (O.Yakimov - DWR UCIP)
 03/07/2014 Needs cleaning and clearing the culvert. (P. Amatya - DWR UCIP)
 FIELD_STRUCT_DESC: 24-inch corrugated metal gravity drainage pipe through the levee, 10.5 feet below the crown. Flap gate on the waterside (WS) end. Concrete U-shaped headwall on each end. Grouted riprap apron on the landside (LS) end. Grouted riprap spillway on the WS end. [Additional Reference(s): DWR Levee Log, 1992 (HLM 3.43). USACE Sacramento O&M Manual, Unit 504, May 1965, Revised 2 February 2011, (HLM 3.43), listed as 24-inch pipe. USACE As-Built Drawing No. 50-04-3685, Sheet 11, STA 470+20, 19 May 1965].

Top of Levee: View of levee crown looking upstream

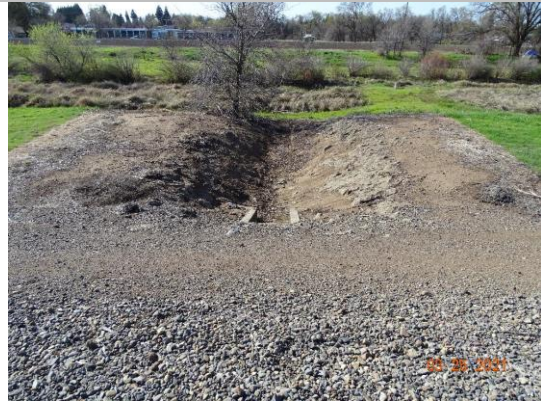
Photo 2 of 3 : UCIP_FA_2023_67683_100550.jpg

Water-Side: View of levee slope looking from crown

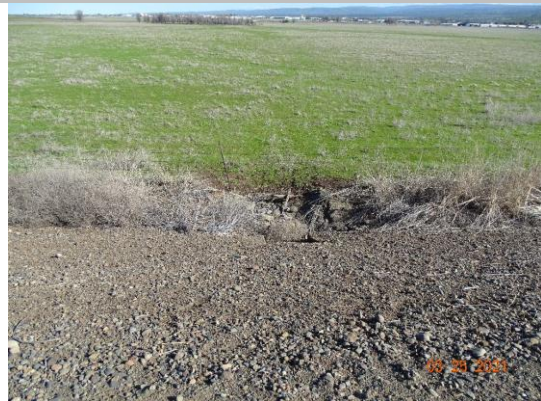
Photo 3 of 3 : UCIP_FA_2023_67683_100551.jpg

Land-Side: View of levee slope looking from crown

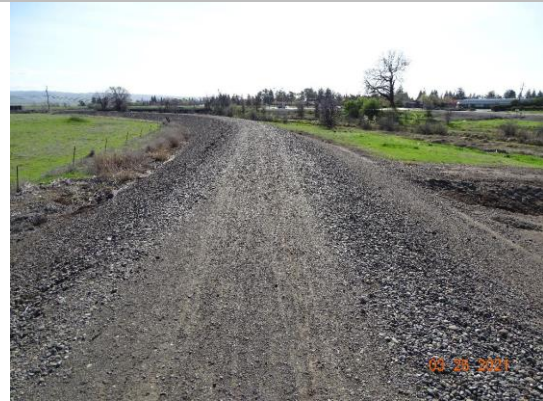
Photo 1 of 3 : UCIP_FA_2023_67684_100555.jpg

Comment Code					
Inspector Comment					
DS_ID:19272 FS_ID:67684 EP_NO: N/A Repair Type: Non-Urgent EVAL Issue: Crossing Status: Found UCIP Comments: 03/25/2021 Record remains Non-Urgent. Debris around culvert has been cleared. No permit has been identified authorizing pipe. DMP internal video inspection has not found pipe integrity issues. LOF of crossing is less or equal to 4. Recommend next video inspection in 5 years. (O.Yakimov - DWR UCIP) 03/07/2014 Needs cleaning and clearing the culvert. (P. Amatya - DWR UCIP) FIELD_STRUCT_DESC: 24-inch corrugated metal gravity drainage pipe through the levee, 9.5 feet below the crown. Flap gate on the waterside (WS) end. Concrete U-shaped headwall on each end. Grouted riprap apron on the landside (LS) end. Grouted riprap spillway on the WS end. [Additional Reference(s): DWR Levee Log, 1992 (HLM 3.59). USACE Sacramento O&M Manual, Unit 504, May 1965, Revised 2 February 2011, (HLM 3.59), listed as 24-inch pipe. USACE As-Built Drawing No. 50-04-3685, Sheet 11, STA 478+40, 19 May 1965]. FS Date: 3/25/2021 11:16:33 AM

Top of Levee: View of levee crown looking upstream

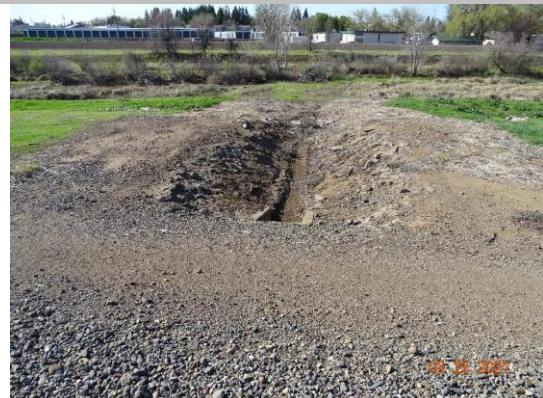
Photo 2 of 3 : UCIP_FA_2023_67684_100556.jpg

Water-Side: View of levee slope looking from crown

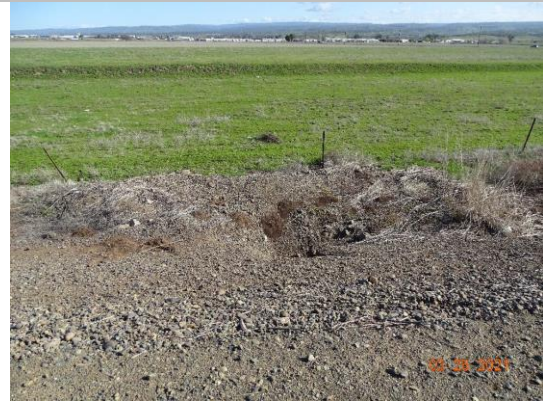
Photo 3 of 3 : UCIP_FA_2023_67684_100557.jpg

Land-Side: View of levee slope looking from crown

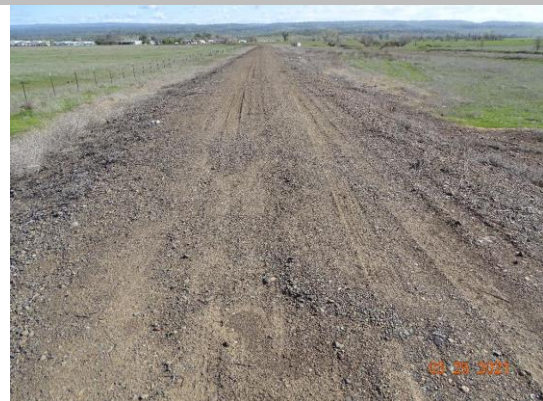
Photo 1 of 3 : UCIP_FA_2023_67687_100570.jpg

DS_ID:19275
FS_ID:67687
EP_NO: N/A
Repair Type: Non-Urgent
EVAL Issue:
Crossing Status: Found
UCIP Comments: 03/25/2021 Record remains Non-Urgent. No permit has been identified authorizing pipe. DMP internal video inspection has not found pipe integrity issues. LOF of crossing is less or equal to 4. Recommend next video inspection in 5 years. (O.Yakimov - DWR UCIP)
03/04/2014 The culvert was working during the field visit. Needs cleaning and clearing on both ends of the pipe. (P. Amatya - DWR UCIP)
FIELD_STRUCT_DESC: 24-inch corrugated metal gravity drainage pipe through the levee, 7.5 feet below the crown. Flap gate on the waterside (WS) end. Concrete U-shaped headwall on each end. Grouted riprap apron on the landside (LS) end. Grouted riprap spillway on the WS end. (Installation of flap gate to existing 24-inch-diameter outfall pipe authorized under Permit No. 18106, 2006 - City of Chico). [Additional Reference(s): DWR Levee Log, 1992 (HLM 3.75). USACE Sacramento O&M Manual, Unit 504, May 1965, Revised 2 February 2011, (HLM 3.76), listed as 24-inch pipe. USACE As-Built Drawing No. 50-04-3685, Sheet 11, STA 486+62, 19 May 1965].

Top of Levee: View of levee crown looking upstream

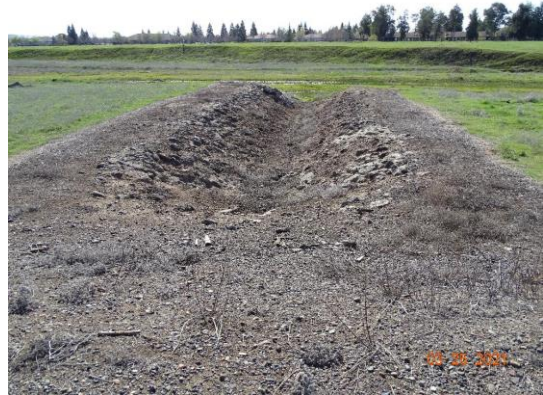
Photo 2 of 3 : UCIP_FA_2023_67687_100571.jpg

Water-Side: View of levee slope looking from crown

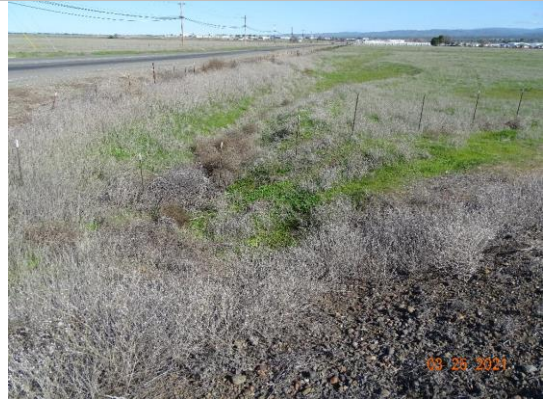
Photo 3 of 3 : UCIP_FA_2023_67687_100572.jpg

Land-Side: View of levee slope looking from crown

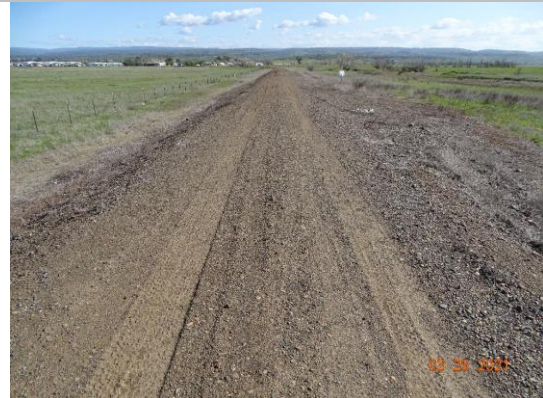
Photo 1 of 3 : UCIP_FA_2023_67688_100576.jpg

Comment Code						
Inspector Comment						
DS_ID:19274 FS_ID:67688 EP_NO: N/A Repair Type: Non-Urgent EVAL Issue: Crossing Status: Not Found UCIP Comments: 03/25/2021 Record is Non-Urgent. Crossing not found. Geophysical results did not confirm presence of pipe through levee. Record will remain in UCIP's inspection records until future Levee Improvement Project can confirm no crossing was found through the levee. No permit has been identified authorizing pipe. (O.Yakimov - DWR UCIP)						
FIELD_STRUCT_DESC: 24-inch corrugated metal gravity drainage pipe through the levee, 10 feet below the crown. Flap gate on the waterside (WS) end. Concrete U-shaped headwall on each end. Grouted riprap apron on the landside (LS) end. Grouted riprap spillway on the WS end. [Additional Reference(s): DWR Levee Log, 1992 (HLM 3.78). USACE Sacramento O&M Manual, Unit 504, May 1965, Revised 2 February 2011, (HLM 3.78), listed as 24-inch pipe. USACE As-Built Drawing No. 50-04-3685, Sheet 11, STA 488+20, 19 May 1965]. FS Date: 3/25/2021 1:25:15 PM

Top of Levee: View of levee crown looking upstream

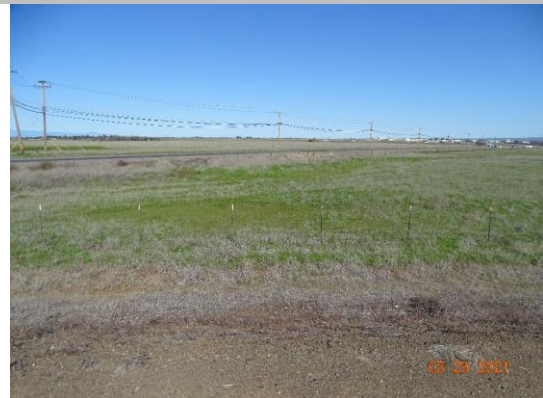
Photo 2 of 3 : UCIP_FA_2023_67688_100577.jpg

Land-Side: View of levee slope looking from crown

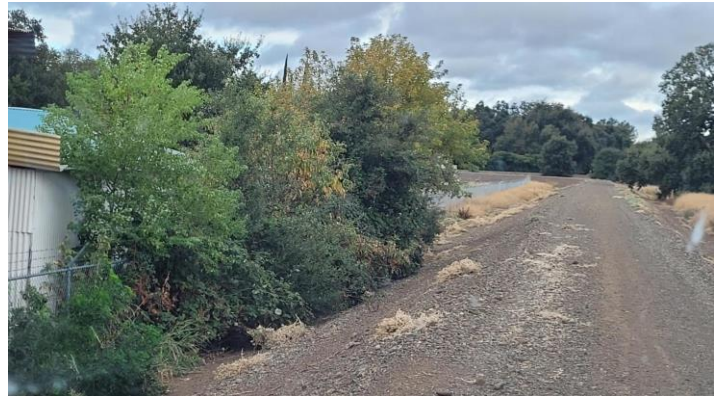
Photo 1 of 1 : FA_2023_NA0003_68_17_20231016_00041.jpg

View of wild growth along the landside toe. Fall 2023.

LM Start	0.16	Rating **	M	Issue No.	17
LM End	0.16	Issue Type +	Ma	Location *	LS
Category	Earthen Levee			GPS Latitude/Longitude	
				Start	End
Item	Vegetation			39.776499°	39.776499°
				-121.848688°	-121.848688°
DWR ID	DWR_NA0003_04_s_2023_17				
Comment Code					
V2 : Remove the wild growth and woody vegetation other than native grasses from the levee slopes.					
Inspector Comment

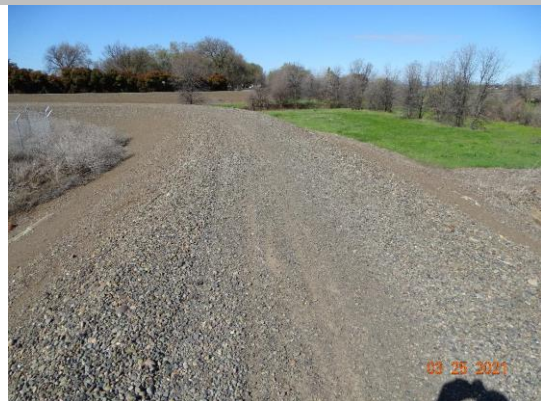
Photo 1 of 3 : UCIP_FA_2023_67692_100580.jpg

Comment Code					
Inspector Comment					
DS_ID:19279					
FS_ID:67692					
EP_NO: N/A					
Repair Type: Non-Urgent					
EVAL Issue:					
Crossing Status: Found					
UCIP Comments: 03/25/2021 Record remains Non-Urgent. No permit has not found pipe integrity issues. LOF of crossing is less or equal to 4. Recommend next video inspection in 5 years. (O.Yakimov - DWR UCIP)					
03/07/2014 Needs cleaning and clearing the culvert (P. Amatya - DWR UCIP)					
FIELD_STRUCT_DESC: 24-inch corrugated metal gravity drainage pipe through the levee, 10 feet below the crown. Flap gate on the waterside (WS) end. Concrete U-shaped headwall on each end. Grouted riprap apron on the landside (LS) end. Grouted riprap spillway on the WS end. [Additional Reference(s): DWR Levee Log, 1992 (HLM 0.28). USACE Sacramento O&M Manual, Unit 504, May 1965, Revised 2 February 2011, (HLM 0.28), listed as 24-inch pipe. USACE As-Built Drawing No. 50-04-3685, Sheets 11 and 41, STA 464+00, 19 May 1965].

Top of Levee: View of levee crown looking downstream

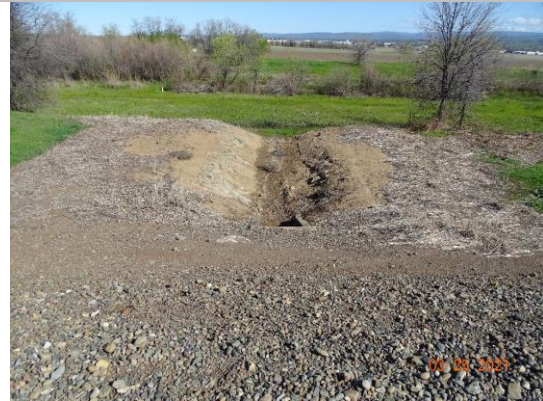
Photo 2 of 3 : UCIP_FA_2023_67692_100581.jpg

Water-Side: View of levee slope looking from crown

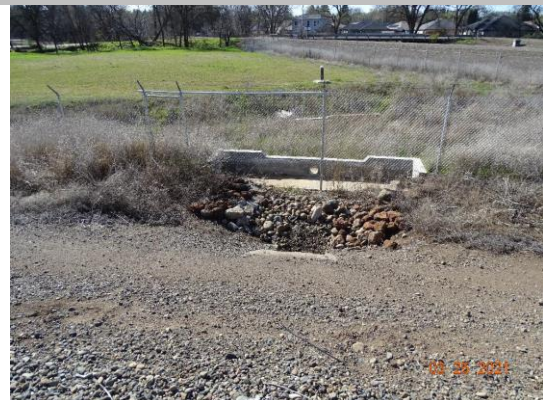
Photo 3 of 3 : UCIP_FA_2023_67692_100582.jpg

Land-Side: View of levee slope looking from crown

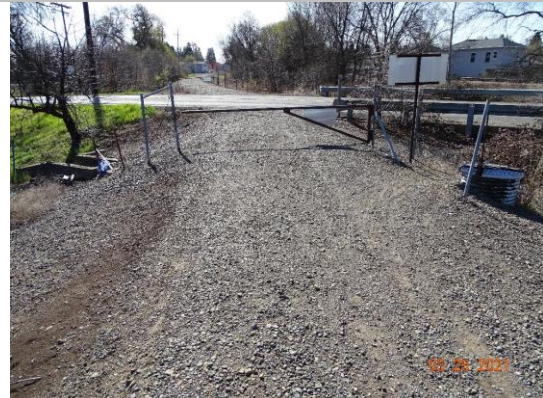
Photo 1 of 3 : UCIP_FA_2023_67693_100586.jpg

Comment Code						
Inspector Comment						
DS_ID:19280						
FS_ID:67693						
EP_NO: N/A						
Repair Type: Non-Urgent						
EVAL Issue:						
Crossing Status: Found						
UCIP Comments: 03/25/2021 Record remains Non-Urgent. Debris around on inlet has been cleared. No permit has been identified authorizing pipe. DMP internal video inspection has not found pipe integrity issues. LOF of crossing is less or equal to 4. Recommend next video inspection in 5 years. (O.Yakimov - DWR UCIP)						
03/07/2014 Slide gate in a CMP riser. Vegetation debris and mud on inlet box. Needs cleaning and clearing the culvert. (P. Amatya - DWR UCIP)						
FIELD_STRUCT_DESC: 24-inch corrugated metal gravity drainage pipe through the levee and under the channel, 9.5 feet below the crown. Slide gate in a corrugated metal pipe (CMP) riser on the waterside (WS) slope. Concrete U-shaped headwall on the landside (LS) end. [Additional Reference(s): DWR Levee Log, 1992 (HLM 0.34). USACE Sacramento O&M Manual, Unit 504, May 1965, Revised 2 February 2011, (HLM 0.34), listed as 24-inch pipe. USACE As-Built Drawing No. 50-04-3685, Sheet 11, between STA 2+20 and STA 3+20, 19 May 1965, shown as existing siphon through both levees and under channel].

Top of Levee: View of levee crown looking upstream

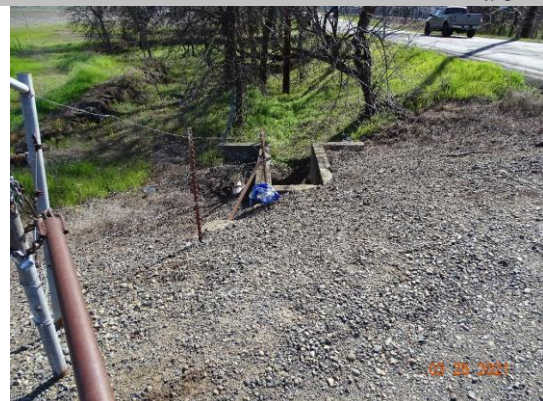
Photo 2 of 3 : UCIP_FA_2023_67693_100588.jpg

Land-Side: View of levee slope looking from crown

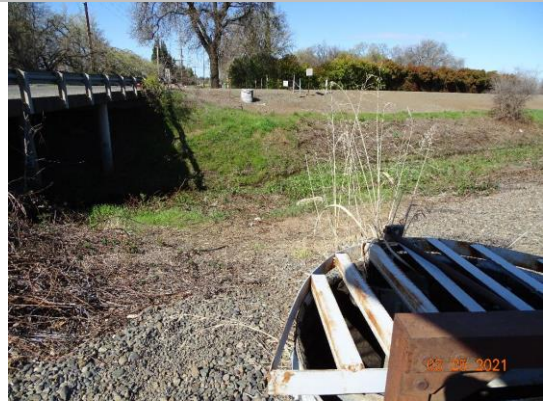
Photo 3 of 3 : UCIP_FA_2023_67693_100589.jpg

Water-Side: Detailed view of levee slope. Pipe outfall not visible on waterside. Crossing DSID 19288 on opposite side of levee

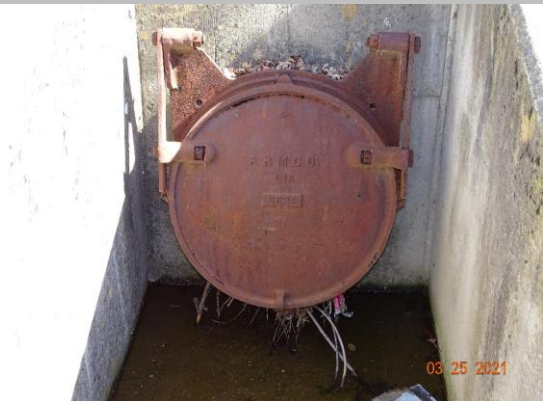
Photo 1 of 3 : UCIP_FA_2023_67694_100595.jpg

DS_ID:19281
FS_ID:67694
EP_NO: N/A
Repair Type: Urgent
EVAL Issue: 3a, Flood Risk
Crossing Status: Found
UCIP Comments: 03/25/2021 Record updated from Non-Urgent to Urgent. Debris inside pipe holds flap gate from complete closing. Backflow may cause flood risk to landside. No permit has been identified authorizing pipe. DMP internal video inspection has not found pipe integrity issues. LOF of crossing is less or equal to 4. Recommend next video inspection in 5 years. (O.Yakimov - DWR UCIP)
03/07/2014 Needs cleaning and clearing the culvert. (P. Amatya - DWR UCIP)
FIELD_STRUCT_DESC: 24-inch corrugated metal gravity drainage pipe through the levee, 8 feet below the crown. Flap gate on the waterside (WS) end. Concrete U-shaped headwall on each end. Grouted riprap apron on the landside (LS) end. Grouted riprap spillway on the WS end. [Additional Reference(s): DWR Levee Log, 1992 (HLM 0.36). USACE Sacramento O&M Manual, Unit 504, May 1965, Revised 2 February 2011, (HLM 0.36), listed as 24-inch pipe. USACE As-Built Drawing No. 50-04-3685, Sheets 11 and 41, STA 4+20, 19 May 1965].

Water-Side: Headwall and flap gate at levee toe

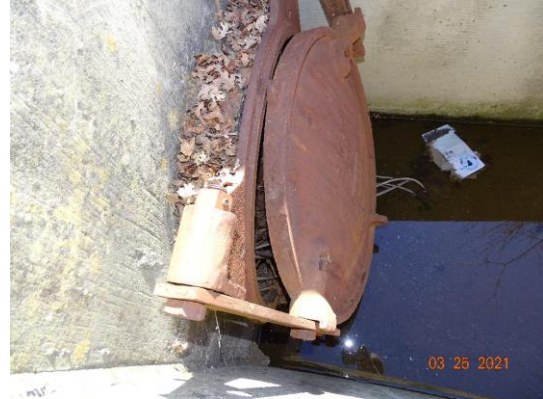
Photo 2 of 3 : UCIP_FA_2023_67694_100596.jpg

Water-Side: Debris inside of pipe blocks flap gate from complete closing

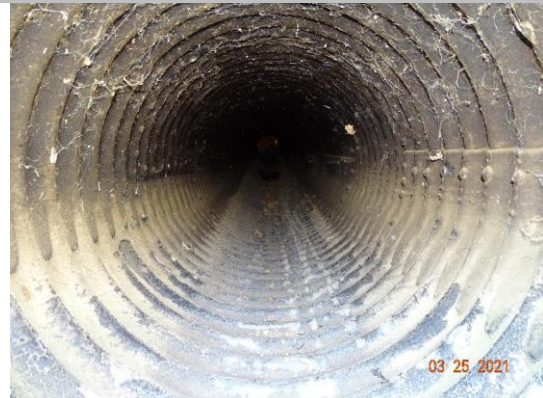
Photo 3 of 3 : UCIP_FA_2023_67694_100598.jpg

Land-Side: View inside of pipe looking from landside end

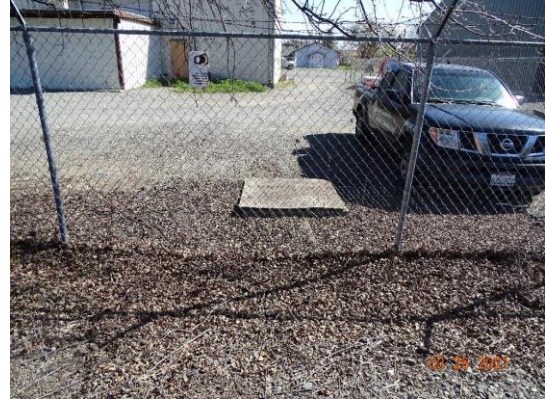
Photo 1 of 3 : UCIP_FA_2023_67757_100818.jpg

Comment Code						
Inspector Comment						
DS_ID:19283 FS_ID:67757 EP_NO: N/A Repair Type: Urgent EVAL Issue: 1, Pipe Integrity Crossing Status: Found UCIP Comments: 03/25/2021 Record updated from No Action Needed to Urgent. DMP internal video inspection has found pipe integrity issues. LOF of crossing is between 5 and 6. Crossing will be monitored until funding becomes available to address the issues. (O.Yakimov - DWR UCIP) 03/07/2014 Concrete vault on landside. Not found- grouted apron on the landward end. (P. Amatya - DWR UCIP) FIELD_STRUCT_DESC: 18-inch corrugated metal gravity drainage pipe through the levee, 4 feet below the crown. Concrete drainage vault in parking space on landside, flap gate on waterside pipe end. Grouted riprap spillway on the waterside (WS) end. [Additional Reference(s): DWR Levee Log, 1992 (HLM 0.65). USACE Sacramento O&M Manual, Unit 504, May 1965, Revised 2 February 2011, (HLM 0.66), listed as 18-inch pipe. USACE As-Built Drawing No. 50-04-3685, Sheet 11, STA 25+30???, 19 May 1965]. FS Date: 3/25/2021 2:07:20 PM

Land-Side: Fence on levee berm. Storm drain manhole covered with plywood sheet on levee berm

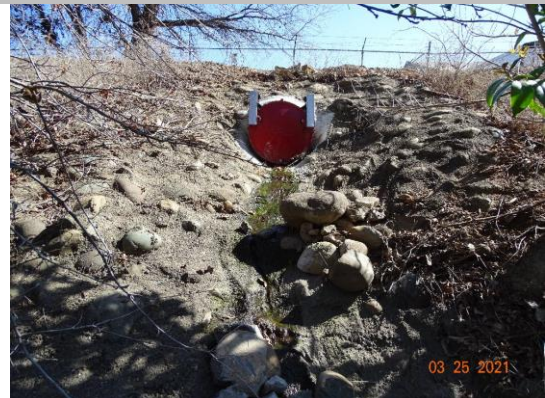
Photo 2 of 3 : UCIP_FA_2023_67757_100820.jpg

Water-Side: View of levee slope looking from toe. Flap gate installed on pipe end

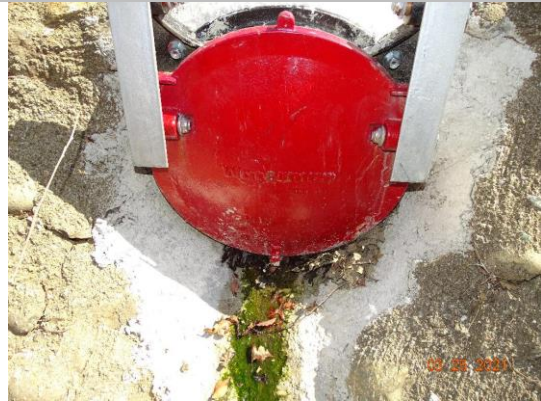
Photo 3 of 3 : UCIP_FA_2023_67757_100821.jpg

Water-Side: Close up view of flap gate on levee slope

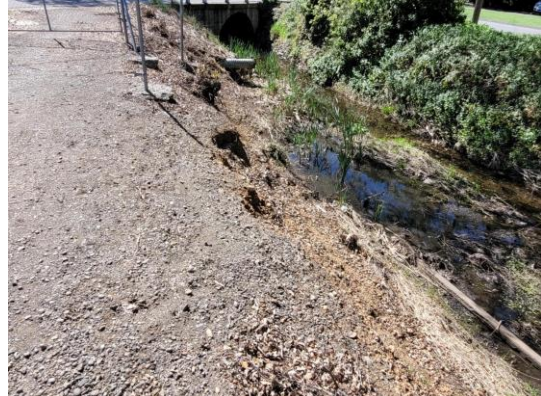
Photo 1 of 1 : FA_2023_NA0003_68_25_20231002_00006.jpg

View of the erosion along the waterside slope. Spring 2022.

LM Start	0.71	Rating **	M	Issue No.	25
LM End	0.71	Issue Type +	Ma	Location *	WS
Category	Earthen Levee			GPS Latitude/Longitude	
				Start	End
Item	Erosion / Bank Caving			39.773019°	39.773019°
				-121.845927°	-121.845927°
DWR ID	DWR_NA0003_04_s_2022_25				
Comment Code					
E2 : Schedule repair of erosion site prior to the next inspection.					
Inspector Comment

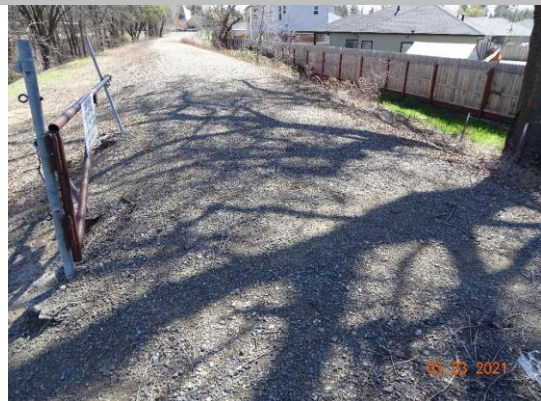
Photo 1 of 3 : UCIP_FA_2023_67765_100840.jpg

Comment Code						
Inspector Comment						
DS_ID:19287						
FS_ID:67765						
EP_NO: N/A						
Repair Type: Non-Urgent						
EVAL Issue:						
Crossing Status: Found						
UCIP Comments: 03/23/2021 Record remains Non-Urgent. Debris has been cleared. No permit has been identified authorizing pipe. DMP internal video inspection has not found pipe integrity issues. LOF of crossing is less or equal to 4. Recommend next video inspection in 5 years. (O.Yakimov - DWR UCIP)						
03/07/2014 Needs cleaning and clearing the culvert. (P. Amatya - DWR UCIP)						
FIELD_STRUCT_DESC: 24-inch corrugated metal gravity drainage pipe through the levee, 9 feet below the crown. Flap gate on the waterside (WS) end. Concrete U-shaped headwall on each end. Grouted riprap apron on the landside (LS) end. Grouted riprap spillway on the WS end. [Additional Reference(s): DWR Levee Log, 1992 (HLM 0.96). USACE Sacramento O&M Manual, Unit 504, May 1965, Revised 2 February 2011, (HLM 0.96), listed as 24-inch pipe. USACE As-Built Drawing No. 50-04-3685, Sheets 11 and 41, STA 4+00, 19 May 1965].

Top of Levee: View of levee crown looking upstream

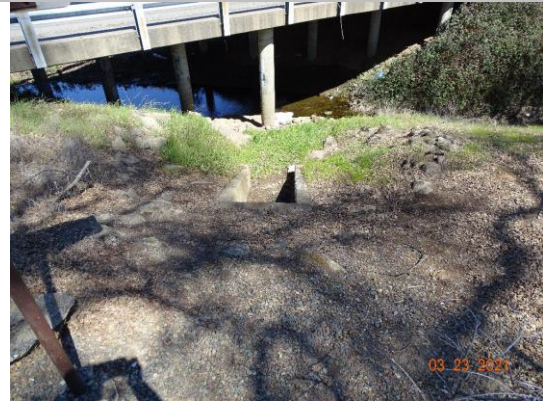
Photo 2 of 3 : UCIP_FA_2023_67765_100841.jpg

Water-Side: View of levee slope looking from crown

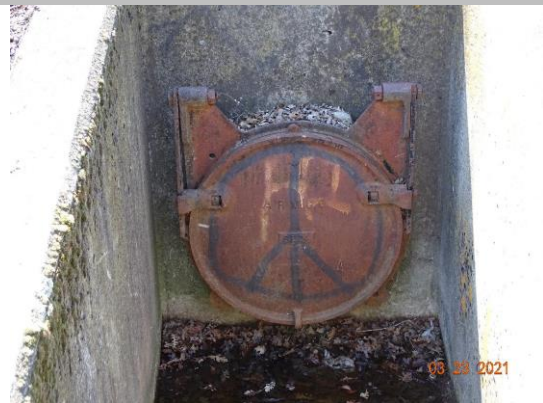
Photo 3 of 3 : UCIP_FA_2023_67765_100845.jpg

Water-Side: Headwall and flap gate at levee toe

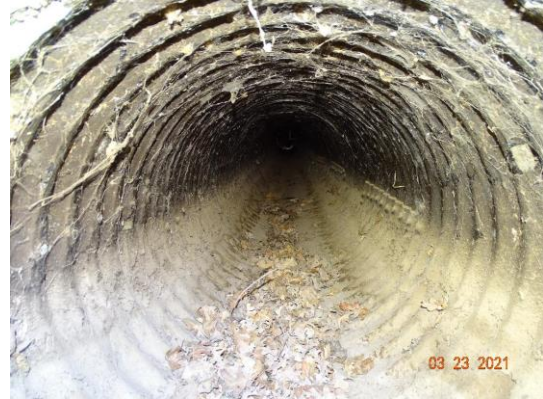
Photo 3 of 3 : UCIP_FA_2023_67774_100888.jpg

Comment Code					
Inspector Comment					
DS_ID:19288 FS_ID:67774 EP_NO: N/A Repair Type: Non-Urgent EVAL Issue: 5, Pipe Damage Crossing Status: Found UCIP Comments: 03/23/2021 Record remains Non-Urgent. DMP internal video inspection has found pipe integrity issues. LOF of crossing is greater than or equal to 4.1 and less than 5. Crossing will be monitored until funding becomes available for rehabilitation. No permit has been identified authorizing pipe. (O.Yakimov - DWR UCIP) 03/07/2014 Slide gate in CMP riser on waterside. No access to CMP riser. Needs cleaning and clearing the culvert. (P. Amatya - DWR UCIP) FIELD_STRUCT_DESC: 24-inch corrugated metal gravity drainage pipe through the levee and under the channel, 9.5 feet below the crown. Slide gate in a pipe riser on the waterside (WS) slope. Concrete U-shaped headwall on the landside (LS) end. [Additional Reference(s): DWR Levee Log, 1992 (HLM 0.98). USACE Sacramento O&M Manual, Unit 504, May 1965, Revised 2 February 2011, (HLM 0.98), listed as 24-inch pipe. USACE As-Built Drawing No. 50-04-3685, Sheet 11, between STA 2+20 and STA 3+20, 19 May 1965, shown as existing siphon through both levees and under channel]. FS Date: 3/23/2021 3:07:34 PM

Land-Side: View inside of pipe looking from landside end

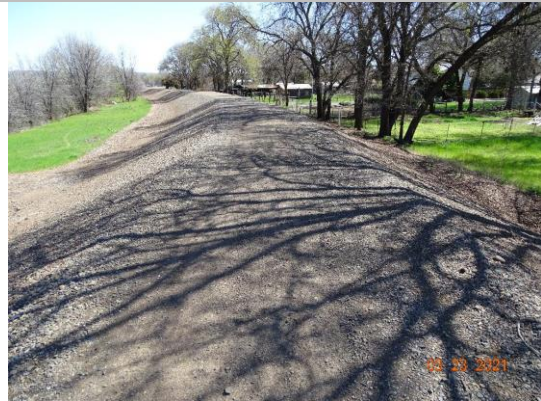
Photo 1 of 3 : UCIP_FA_2023_67776_100894.jpg

Comment Code						
Inspector Comment						
DS_ID:19289 FS_ID:67776 EP_NO: N/A Repair Type: Non-Urgent EVAL Issue: 11, Maintenance Compliance Issue Crossing Status: Found UCIP Comments: 03/23/2021 Record remains Non-Urgent. Flap gate at waterside headwall is stuck closed. Hinges may need lubrication. No permit has been identified authorizing pipe. DMP internal video inspection has not found pipe integrity issues. LOF of crossing is less or equal to 4. Recommend next video inspection in 5 years. (O.Yakimov - DWR UCIP) 03/07/2014 Needs cleaning and clearing the culvert. (P. Amatya - DWR UCIP) FIELD_STRUCT_DESC: 24-inch corrugated metal gravity drainage pipe through the levee, 11 feet below the crown. Flap gate on the waterside (WS) end. Concrete U-shaped headwall on each end. Grouted riprap apron on the landside (LS) end. Grouted riprap spillway on the WS end. [Additional Reference(s): DWR Levee Log, 1992 (HLM 1.15). USACE Sacramento O&M Manual, Unit 504, May 1965, Revised 2 February 2011, (HLM 1.15), listed as 24-inch pipe. USACE As-Built Drawing No. 50-04-3685, Sheet 41, STA 455+00, 19 May 1965]. FS Date: 3/23/2021 3:10:19 PM

Top of Levee: View of levee crown looking upstream

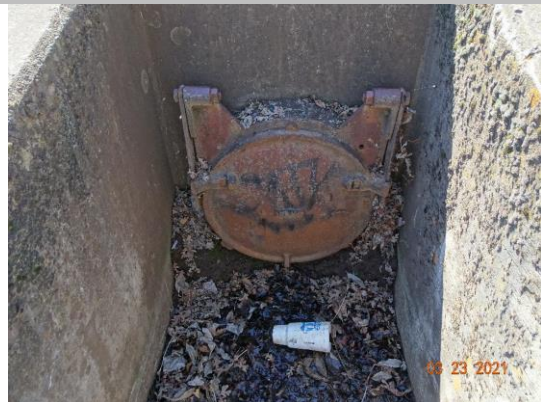
Photo 2 of 3 : UCIP_FA_2023_67776_100899.jpg

Water-Side: U-shaped headwall and flap gate at levee toe

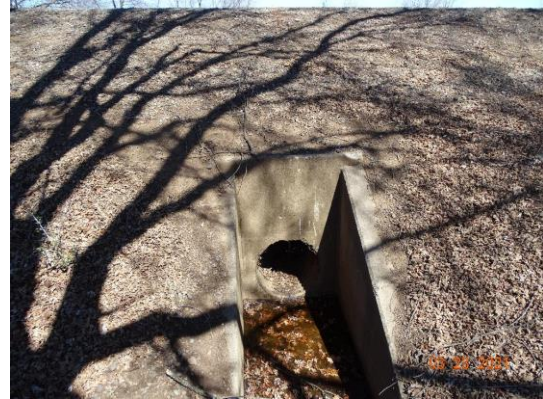
Photo 3 of 3 : UCIP_FA_2023_67776_100897.jpg

Land-Side: Levee slope, headwall, and pipe inlet

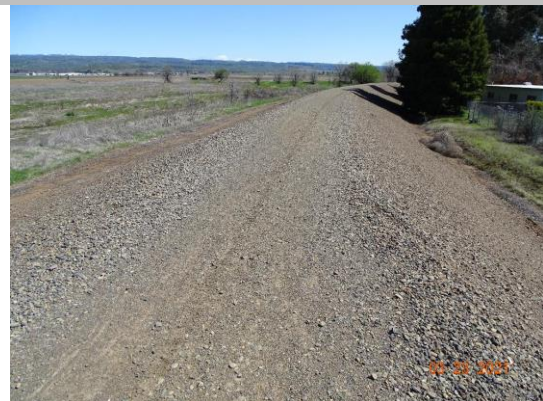
Photo 1 of 3 : UCIP_FA_2023_67777_100900.jpg

DS_ID:19290
 FS_ID:67777
 EP_NO: N/A
 Repair Type: Non-Urgent
 EVAL Issue:
 Crossing Status: Found
 UCIP Comments: 03/23/2021 Record remains Non-Urgent. Debris has been cleared. No permit has been identified authorizing pipe. DMP internal video inspection has not found pipe integrity issues. LOF of crossing is less or equal to 4. Recommend next video inspection in 5 years. (O.Yakimov - DWR UCIP)
 03/07/2014 Needs cleaning and clearing the culvert. (P. Amatya - DWR UCIP)
 FIELD_STRUCT_DESC: 24-inch corrugated metal gravity drainage pipe through the levee, 13 feet below the crown. Flap gate on the waterside (WS) end. Concrete U-shaped headwall on each end. Grouted riprap apron on the landside (LS) end. Grouted riprap spillway on the WS end.
 [Additional Reference(s): DWR Levee Log, 1992 (HLM 1.39). USACE Sacramento O&M Manual, Unit 504, May 1965, Revised 2 February 2011, (HLM 1.41), listed as 24-inch pipe. USACE As-Built Drawing No. 50-04-3685, Sheets 9 and 40, STA 442+05, 19 May 1965].

Top of Levee: View of levee crown looking upstream

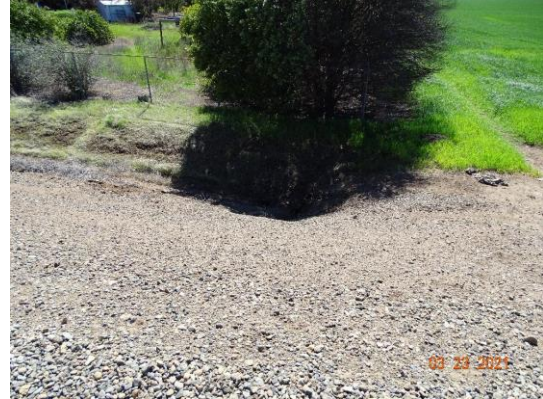
Photo 2 of 3 : UCIP_FA_2023_67777_100901.jpg

Land-Side: View of levee slope looking from crown

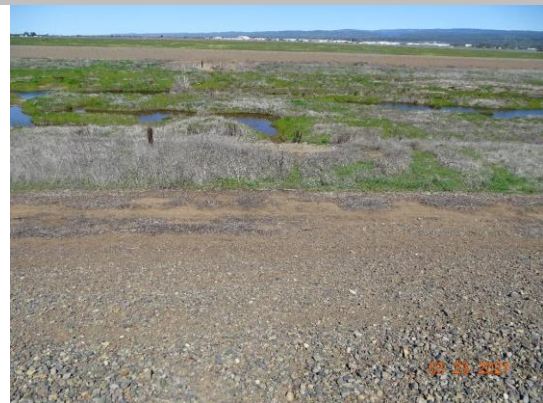
Photo 3 of 3 : UCIP_FA_2023_67777_100902.jpg

Water-Side: View of levee slope looking from crown

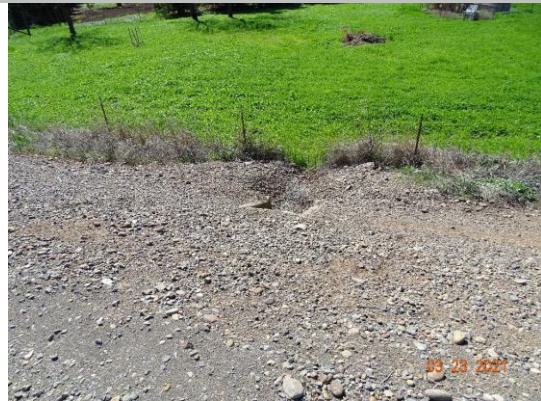
Photo 2 of 3 : UCIP_FA_2023_67779_100909.jpg

Land-Side: View of levee slope looking from crown

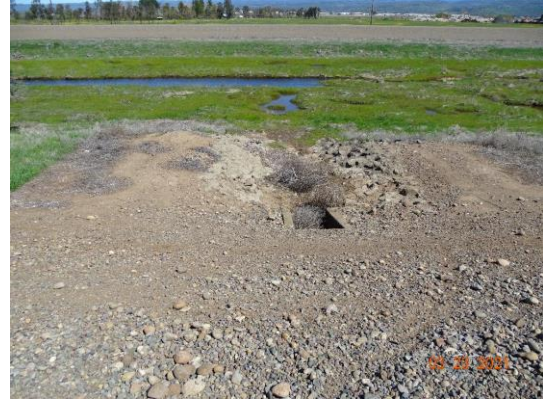
Photo 3 of 3 : UCIP_FA_2023_67779_100910.jpg

Water-Side: View of levee slope looking from crown

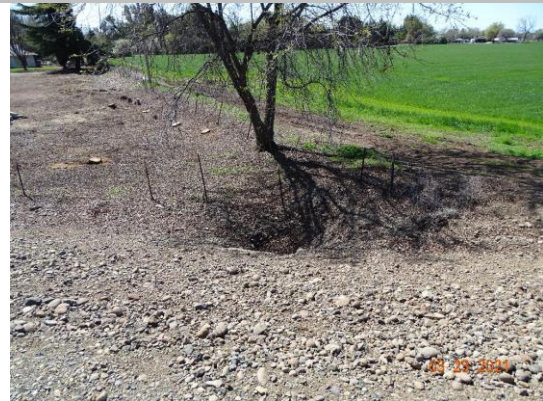
Photo 1 of 3 : UCIP_FA_2023_67780_100915.jpg

DS_ID:19292
 FS_ID:67780
 EP_NO: N/A
 Repair Type: No Action Needed
 EVAL Issue:
 Crossing Status: Found
 UCIP Comments: 09/15/2023 Record updated from Non-Urgent to No Action Needed. Pipe was CIPP lined. DMP internal video inspection has found none or minor pipe defects. Recommend next video inspection in 5 years. (O. Yakimov - DWR UCIP)
 03/23/2021 Record remains Non-Urgent. Debris has been cleared. DMP internal video inspection has found pipe integrity issues. LOF of crossing is greater than or equal to 4.1 and less than 5. Crossing will be monitored until funding becomes available for rehabilitation. No permit has been identified authorizing pipe. (O.Yakimov - DWR UCIP)
 03/07/2014 Needs cleaning and clearing the culvert. (P. Amatya - DWR UCIP)
 FIELD_STRUCT_DESC: 24-inch CIPP-lined corrugated metal gravity drainage pipe through the levee, 11 feet below the crown. Flap gate on the waterside (WS) end. Concrete U-shaped headwall on each end. Grouted riprap apron on the landside (LS) end. Grouted riprap spillway on the WS end. [Additional Reference(s): DWR Levee Log, 1992 (HLM 2.56). USACE Sacramento O&M Manual, Unit 504, May 1965, Revised 2 February 2011, (HLM 2.56), listed as 24-inch pipe. USACE As-Built Drawing No. 50-04-3685, Sheets 7 and 41, STA 382+90, 19 May 1965].

Land-Side: View of levee slope looking from crown

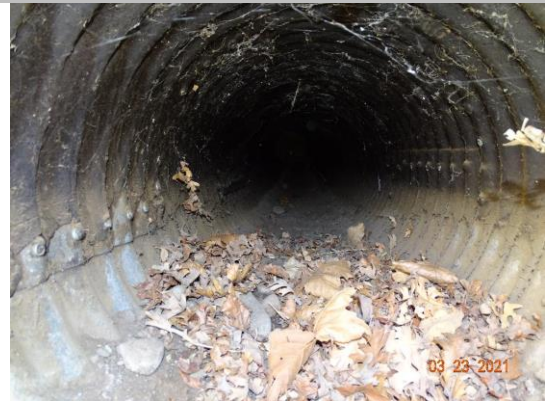
Photo 3 of 3 : UCIP_FA_2023_67780_100919.jpg

Water-Side: View inside of pipe looking from landside end

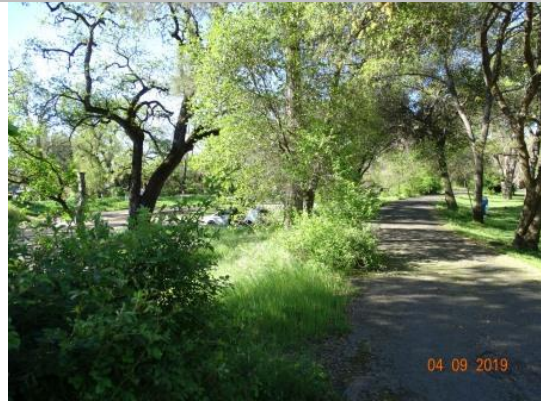
Photo 1 of 1 : FA_2023_NA0003_69_1_20231002_00001.jpg

LM Start	0.03	Rating **	M	Issue No.	1
LM End	0.20	Issue Type +	Ma	Location *	LS
Category	Earthen Levee			GPS Latitude/Longitude	
				Start	End
Item	Vegetation			39.763164°	39.761860°
				-121.790335°	-121.792635°
DWR ID	DWR_NA0003_05_s_2012_1				
Comment Code					
V2 : Remove the wild growth and woody vegetation other than native grasses from the levee slopes.					
Inspector Comment

View of the wild growth on the landside slope. Spring 2019.
