**Flood Control Project Maintenance  
Levee Inspections**

**Maintenance Issue Types Only, Levee Inspection Report By Mile - Fall 2024**

**Butte County Department of Public Works**

Waterway	Bank	Unit Miles	Inspection Start/End	Inspector
Unit No. 01 Mud Creek	Right	6.80	09/19/2024 09/19/2024	Makar Sokol

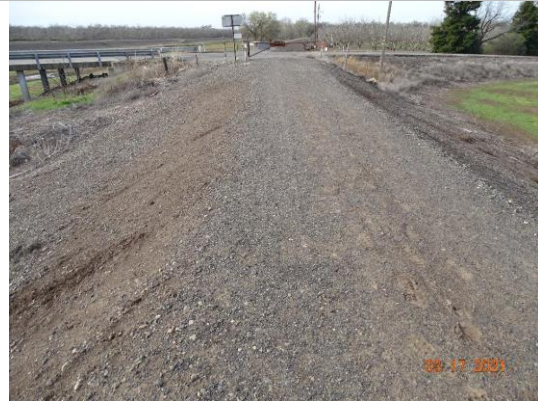
Photo 1 of 3 : UCIP\_FA\_2024\_77889\_99222.jpg

Top of Levee: View of levee crown looking downstream

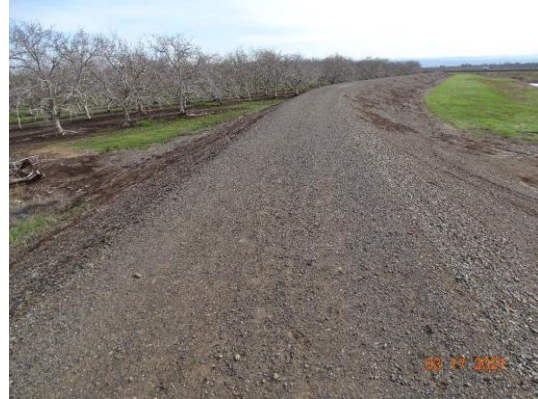
Photo 1 of 3 : UCIP\_FA\_2024\_67238\_99231.jpg

Comment Code						
Inspector Comment						
DS_ID:19211 FS_ID:67238 EP_NO: N/A Repair Type: No Action Needed EVAL Issue: Crossing Status: Found UCIP Comments: 09/15/2023 Record updated from Non-Urgent to No Action Needed. Pipe was CIPP lined. DMP internal video inspection has found none or minor pipe defects. Recommend next video inspection in 5 years. (O. Yakimov - DWR UCIP) 03/17/2021 Record remains Non-Urgent. Vegetation on waterside has been cleared. No permit has been identified authorizing pipe. DMP internal video inspection has found pipe integrity issues. LOF of crossing is greater than or equal to 4.1 and less than 5. Crossing will be monitored until funding becomes available for rehabilitation. (O.Yakimov - DWR UCIP) 02/20/2014 Vegetation debris on waterside. Needs clearing and cleaning. (P. Amatya - DWR UCIP) FIELD_STRUCT_DESC: 24-inch CIPP-lined corrugated metal gravity drainage pipe through the levee, 12 feet below the crown. Flap gate on the waterside (WS) end. Concrete U-shaped headwall on each end. Grouted riprap apron on the landside (LS) end. Grouted riprap spillway on the WS end. [Additional Reference(s): DWR Levee Log, 1992 (HLM 1.01). USACE Sacramento O&M Manual, Unit 504, May 1965, Revised 2 February 2011, (HLM 1.03), listed as 24-inch pipe. USACE As-Built Drawing No. 50-04-3685, Sheet 3, STA 132+00, 19 May 1965. USACE As-Built Drawing No. 50-04-3685, Sheet 41 table of drainage structures, STA 132+00, 19 May 1965]. FS Date: 3/17/2021

Top of Levee: View of levee crown looking upstream

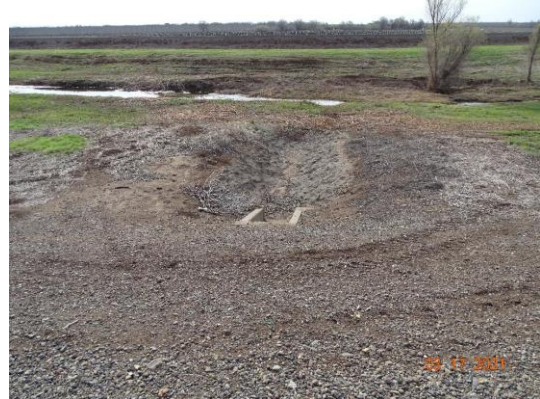
Photo 2 of 3 : UCIP\_FA\_2024\_67238\_99232.jpg

Water-Side: View of levee slope looking from crown

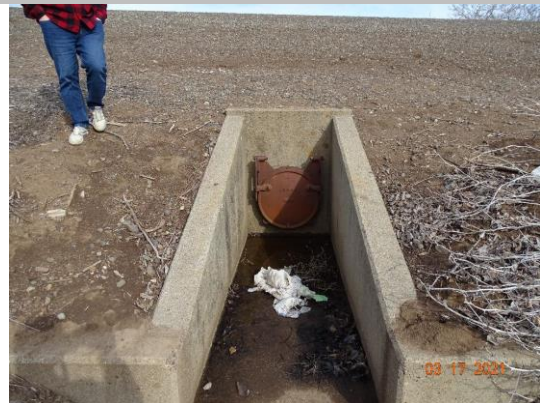
Photo 3 of 3 : UCIP\_FA\_2024\_67238\_99236.jpg

Water-Side: Headwall and flap gate at levee toe

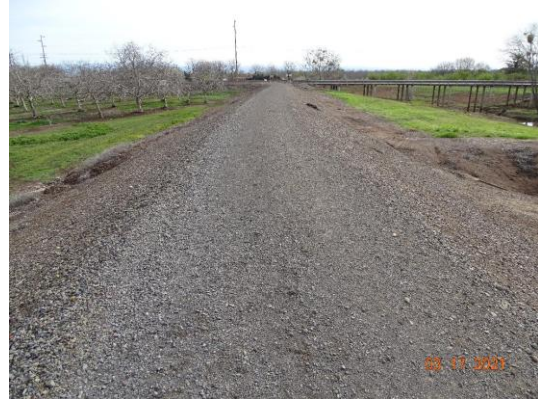
Photo 1 of 3 : UCIP\_FA\_2024\_67239\_99237.jpg

Comment Code						
Inspector Comment						
DS_ID:19212 FS_ID:67239 EP_NO: N/A Repair Type: Non-Urgent EVAL Issue: 5, Pipe Damage Crossing Status: Found UCIP Comments: 09/23/2024 DMP internal video inspection has found moderate pipe defects. Crossing will be monitored until funding becomes available for rehabilitation. (O. Yakimov - DWR UCIP) 03/17/2021 Record updated from No Action Needed to Non-Urgent. No permit has been identified authorizing pipe. DMP internal video inspection has not found pipe integrity issues. LOF of crossing is less or equal to 4.0. Recommend next video inspection in 5 years. (O.Yakimov - DWR UCIP) 08/29/2016: Shawn Bates of NA0003 has cleared the LS and WS of debris and blockage; WS gate functions properly now. Crossing has been downgraded from Urgent to No Action Needed. (K. Fazel - UCIP) 08/11/2016: Same as last inspection. (K. Fazel - UCIP) 02/20/2014: No riprap spillway on waterside. Needs cleaning and clearing of debris. Flap gate was not fully closed. (P. Amatya - DWR UCIP) FIELD_STRUCT_DESC: 24-inch corrugated metal gravity drainage pipe through the levee, 13 feet below the crown. Flap gate on the waterside (WS) end. Concrete U-shaped headwall on each end. Grouted riprap apron on the landside (LS) end. Grouted riprap spillway on the WS end. [Additional Reference(s): DWR Levee Log, 1992 (HLM 1.90). USACE Sacramento O&M Manual, Unit 504, May 1965, Revised 2 February 2011, (HLM 1.95), listed as 24-inch pipe. USACE As-Built Drawing No. 50-04-3685, Sheet 4, STA 179+60, 19 May 1965. USACE As-Built Drawing No. 50-04-3685, Sheet 41 table of drainage structures, STA 179+60, 19 May 1965]. FS Date: 3/17/2021 9:01:17 AM

Top of Levee: View of levee crown looking upstream

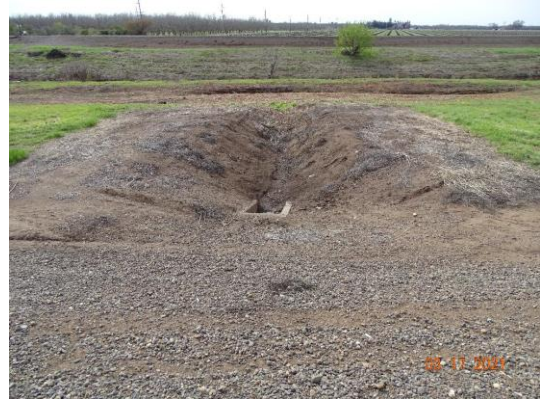
Photo 2 of 3 : UCIP\_FA\_2024\_67239\_99238.jpg

Water-Side: View of levee slope looking from crown

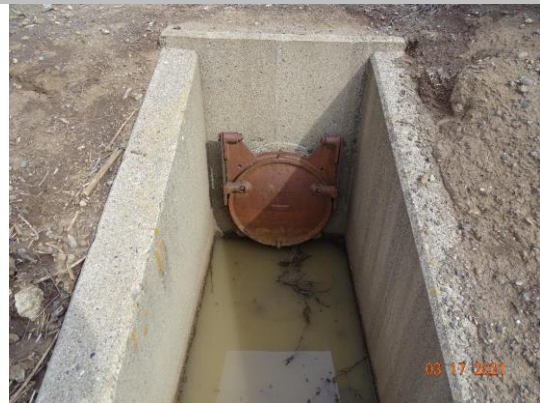
Photo 3 of 3 : UCIP\_FA\_2024\_67239\_99242.jpg

Water-Side: Headwall and flap gate at levee toe

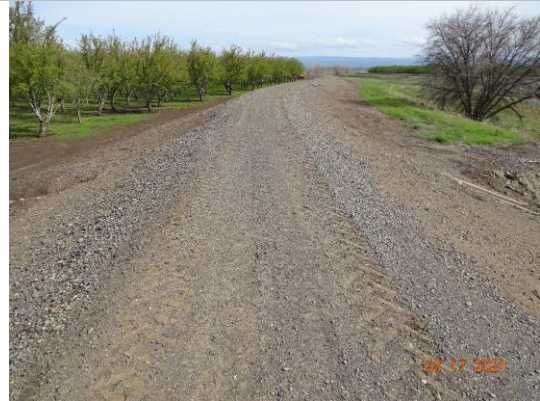
Photo 1 of 3 : UCIP\_FA\_2024\_67246\_99270.jpg

Comment Code						
Inspector Comment						
DS_ID:19216 FS_ID:67246 EP_NO: N/A Repair Type: Non-Urgent EVAL Issue: Crossing Status: Found UCIP Comments: 03/17/2021 Record remains Non-Urgent. No permit has been identified authorizing pipe. DMP internal video inspection has not found pipe integrity issues. LOF of crossing is less or equal to 4.0. Recommend next video inspection in 5 years. (O.Yakimov - DWR UCIP) 02/20/2014 Inlet and outlet needs cleaning and clearing of debris. (P. Amatya - DWR UCIP) FIELD_STRUCT_DESC: 24-inch corrugated metal gravity drainage pipe through the levee, 8.5 feet below the crown. Flap gate on the waterside (WS) end. Concrete U-shaped headwall on each end. Grouted riprap apron on the landside (LS) end. Grouted riprap spillway on the WS end. [Additional Reference(s): DWR Levee Log, 1992 (HLM 3.11). USACE Sacramento O&M Manual, Unit 504, May 1965, Revised 2 February 2011, (HLM 3.11), listed as 24-inch pipe. USACE As-Built Drawing No. 50-04-3685, Sheet 5, STA 239+60, 19 May 1965. USACE As-Built Drawing No. 50-04-3685, Sheet 41 table of drainage structures, STA 239+60, 19 May 1965]. FS Date: 3/17/2021 10:06:03 AM

Top of Levee: View of levee crown looking upstream

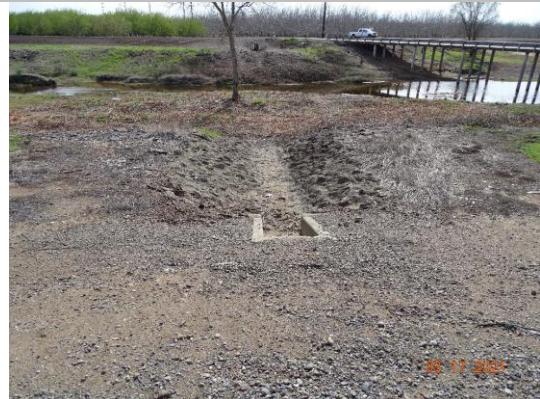
Photo 2 of 3 : UCIP\_FA\_2024\_67246\_99272.jpg

Water-Side: View of levee slope looking from crown

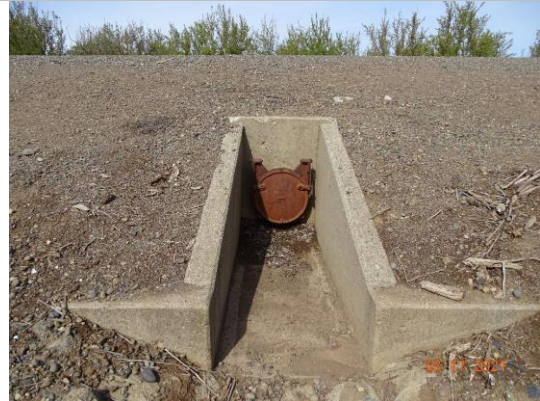
Photo 3 of 3 : UCIP\_FA\_2024\_67246\_99273.jpg

Water-Side: Headwall and flap gate at levee toe

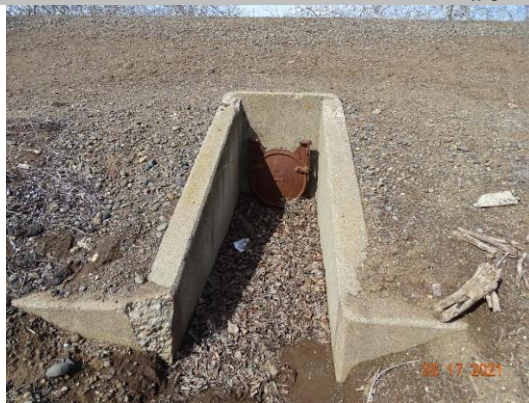
Photo 3 of 3 : UCIP\_FA\_2024\_67247\_99281.jpg

Water-Side: Headwall and flap gate at levee toe

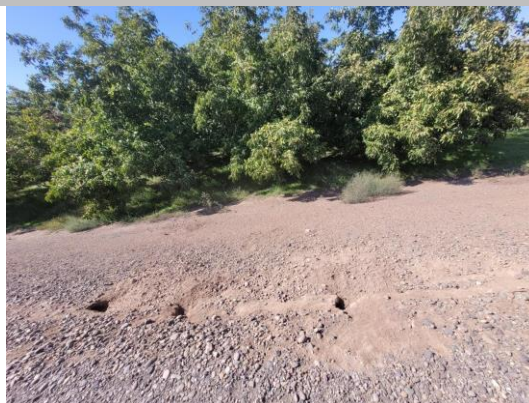
Photo 1 of 1 : FA\_2024\_NA0003\_64\_27\_20240924\_00003.jpg

LM Start	3.19	Rating **	M	Issue No.	27
LM End	3.21	Issue Type +	Ma	Location *	LS
Category	Earthen Levee			GPS Latitude/Longitude	
				Start	End
Item	Animal Control			39.763087°	39.763493°
				-121.909616°	-121.909440°
DWR ID	DWR_NA0003_01_f_2022_27				
Comment Code					
A3 : No rodents visible, but rodent burrows visible; need to backfill and compact or grout burrows.					
Inspector Comment

View of animal burrows along the landside slope. Fall 2022.

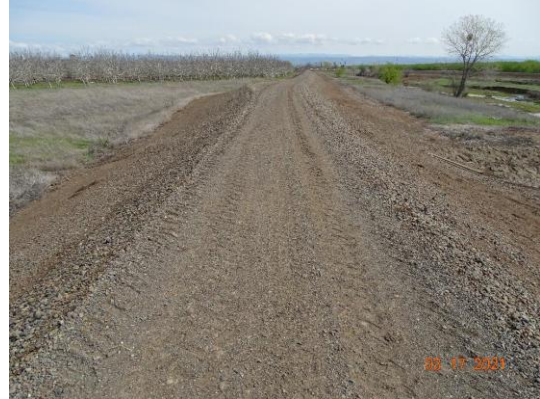
Photo 1 of 3 : UCIP\_FA\_2024\_67248\_99282.jpg

Comment Code					
Inspector Comment					
DS_ID:19218 FS_ID:67248 EP_NO: N/A Repair Type: Non-Urgent EVAL Issue: Crossing Status: Found UCIP Comments: 03/17/2021 Record remains Non-Urgent. No permit has been identified authorizing pipe. DMP internal video inspection has not found pipe integrity issues. LOF of crossing is less or equal to 4.0. Recommend next video inspection in 5 years. (O.Yakimov - DWR UCIP) 02/20/2014 Needs cleaning and clearing of debris. (P. Amatya - DWR UCIP) FIELD_STRUCT_DESC: 24-inch corrugated metal gravity drainage pipe through the levee, 10 feet below the crown. Flap gate on the waterside (WS) end. Concrete U-shaped headwall on each end. Grouted riprap apron on the landside (LS) end. Grouted riprap spillway on the WS end. [Additional Reference(s): DWR Levee Log, 1992 (HLM 3.48). USACE Sacramento O&M Manual, Unit 504, May 1965, Revised 2 February 2011, (HLM 3.48), listed as 24-inch pipe. USACE As-Built Drawing No. 50-04-3685, Sheet 5, STA 258+70, 19 May 1965. USACE As-Built Drawing No. 50-04-3685, Sheet 41 table of drainage structures, STA 258+70, 19 May 1965]. FS Date: 3/17/2021 10:18:14 AM

Top of Levee: View of levee crown looking upstream

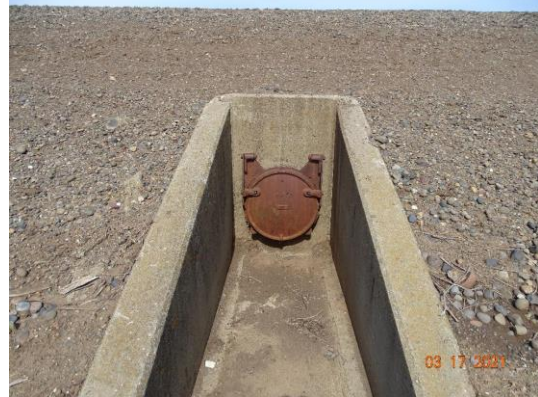
Photo 3 of 3 : UCIP\_FA\_2024\_67248\_99287.jpg

Water-Side: Headwall and flap gate at levee toe

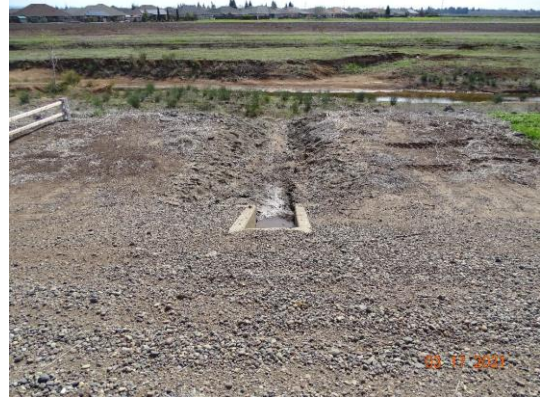
Photo 2 of 3 : UCIP\_FA\_2024\_67249\_99289.jpg

DS\_ID:19219  
FS\_ID:67249  
EP\_NO: N/A  
Repair Type: Non-Urgent  
EVAL Issue:  
Crossing Status: Found  
UCIP Comments: 03/17/2021 Record remains Non-Urgent. No permit has been identified authorizing pipe. DMP internal video inspection has not found pipe integrity issues. LOF of crossing is less or equal to 4.0. Recommend next video inspection in 5 years. (O.Yakimov - DWR UCIP)  
02/20/2014 Needs cleaning and clearing of debris in both ends of the pipe. (P. Amatya - DWR UCIP)  
FIELD\_STRUCT\_DESC: 24-inch corrugated metal gravity drainage pipe through the levee, 9 feet below the crown. Flap gate on the waterside (WS) end. Concrete U-shaped headwall on each end. Grouted riprap apron on the landside (LS) end. Grouted riprap spillway on the WS end. [Additional Reference(s): DWR Levee Log, 1992 (HLM 4.08). USACE Sacramento O&M Manual, Unit 504, May 1965, Revised 2 February 2011, (HLM 4.08), listed as 24-inch pipe. USACE As-Built Drawing No. 50-04-3685, Sheet 41 table of drainage structures, STA 289+20, 19 May 1965].

Water-Side: View of levee slope looking from crown

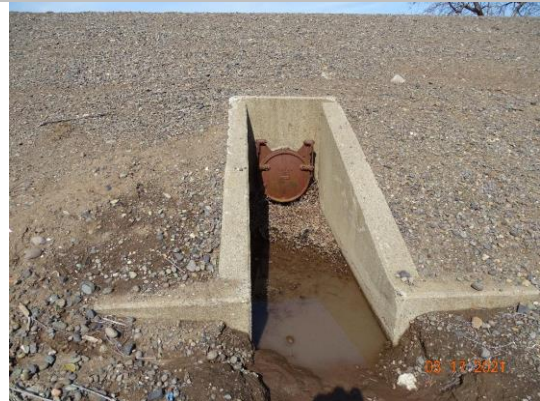
Photo 3 of 3 : UCIP\_FA\_2024\_67249\_99293.jpg

Water-Side: Headwall and flap gate at levee toe

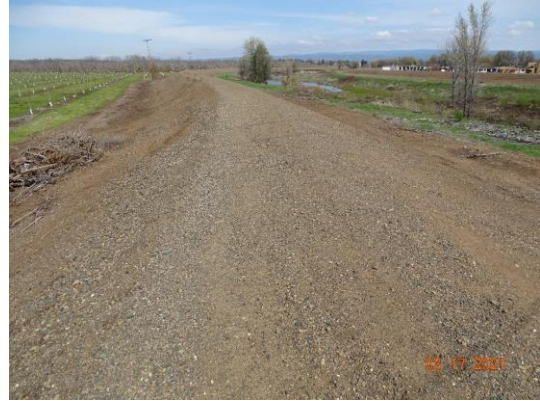
Photo 1 of 3 : UCIP\_FA\_2024\_67250\_99294.jpg

Comment Code					
Inspector Comment					
DS_ID:19220 FS_ID:67250 EP_NO: N/A Repair Type: Non-Urgent EVAL Issue: Crossing Status: Found UCIP Comments: 03/17/2021 Record remains Non-Urgent. Debris has been cleared. No permit has been identified authorizing pipe. DMP internal video inspection has not found pipe integrity issues. LOF of crossing is less or equal to 4.0. Recommend next video inspection in 5 years. (O.Yakimov - DWR UCIP) 02/20/2014 Needs cleaning and clearing of debris. (P. Amatya - DWR UCIP) FIELD_STRUCT_DESC: 24-inch corrugated metal gravity drainage pipe through the levee, 13 feet below the crown. Flap gate on the waterside (WS) end. Concrete U-shaped headwall on each end. Grouted riprap apron on the landside (LS) end. Grouted riprap spillway on the WS end. [Additional Reference(s): DWR Levee Log, 1992 (HLM 4.57). USACE Sacramento O&M Manual, Unit 504, May 1965, Revised 2 February 2011, (HLM 4.58), listed as 24-inch pipe. USACE As-Built Drawing No. 50-04-3685, Sheet 6, STA 315+18, 19 May 1965]. FS Date: 3/17/2021 10:24:31 AM

Top of Levee: View of levee crown looking upstream

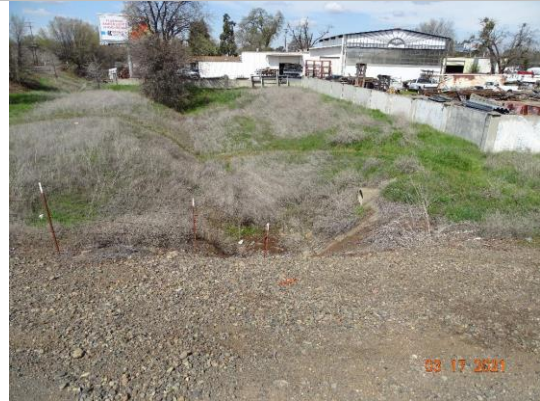
Photo 2 of 3 : UCIP\_FA\_2024\_67286\_99400.jpg

DS\_ID:19222  
FS\_ID:67286  
EP\_NO: N/A  
Repair Type: Non-Urgent  
EVAL Issue:  
Crossing Status: Found  
UCIP Comments: 03/17/2021 Record updated from No Action Needed to Non-Urgent. No permit has been identified authorizing pipe. DMP internal video inspection has not found pipe integrity issues. LOF of crossing is less or equal to 4.0. Recommend next video inspection in 5 years. (O.Yakimov - DWR UCIP)  
02/20/2014 Slide gate in CM standpipe on waterside levee slope. (P. Amatya - DWR UCIP)  
FIELD\_STRUCT\_DESC: 36-inch corrugated metal gravity drainage pipe through the levee, 17 feet below the crown. Slide gate in a corrugated metal standpipe on the waterside (WS) slope. Flap gate on the WS end. Concrete U-shaped headwall on each end. Grouted riprap apron on the landside (LS) end. Grouted riprap spillway on the WS end. [Additional Reference(s): DWR Levee Log, 1992 (HLM 5.22). USACE Sacramento O&M Manual, Unit 504, May 1965, Revised 2 February 2011, (HLM 5.22), listed as 36-inch pipe. USACE As-Built Drawing No. 50-04-3685, Sheet 7, from STA 348+25 to STA 352+50, 19 May 1965].

Land-Side: View of levee slope looking from crown. Drainage ditch on landside

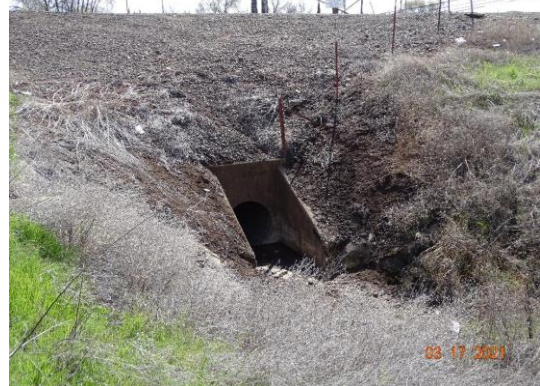
Photo 3 of 3 : UCIP\_FA\_2024\_67286\_99404.jpg

Land-Side: Headwall and pipe inlet in drainage ditch at levee toe

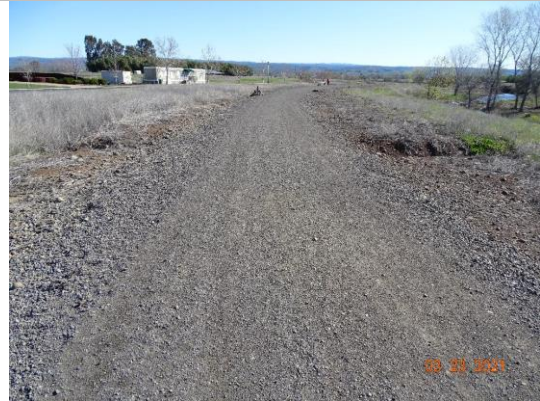
Photo 1 of 3 : UCIP\_FA\_2024\_67292\_99434.jpg

Comment Code						
Inspector Comment						
DS_ID:19226 FS_ID:67292 EP_NO: N/A Repair Type: Non-Urgent EVAL Issue: Crossing Status: Not Found UCIP Comments: 03/23/2021 Record is Non-Urgent. Crossing not found. A valley on waterside slope may indicate former pipe location. Need to confirm if pipe was removed. No permit has been identified authorizing pipe installation. (O.Yakimov - DWR UCIP) FIELD_STRUCT_DESC: 18-inch corrugated metal gravity drainage pipe through the levee, 2 feet below the crown. Pipe is open on both ends. Both ends appear to be covered with rock. [Additional Reference(s): DWR Levee Log, 1992 (HLM 7.00). USACE Sacramento O&M Manual, Unit 504, May 1965, Revised 2 February 2011, (HLM 7.01), listed as 18-inch pipe. USACE As-Built Drawing No. 50-04-3685, Sheet 8, STA 80+70, 19 May 1965]. FS Date: 3/23/2021 11:21:39 AM

Top of Levee: View of levee crown looking upstream

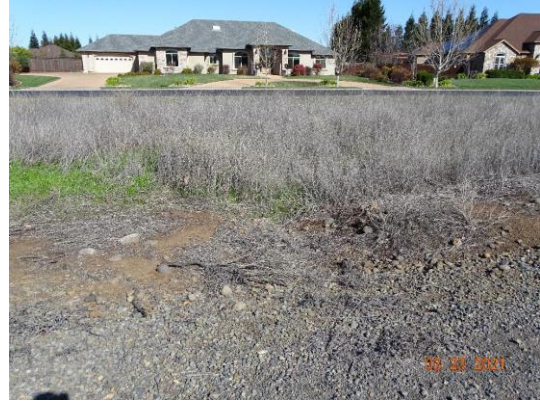
Photo 3 of 3 : UCIP\_FA\_2024\_67292\_99436.jpg

Land-Side: View of levee slope looking from crown

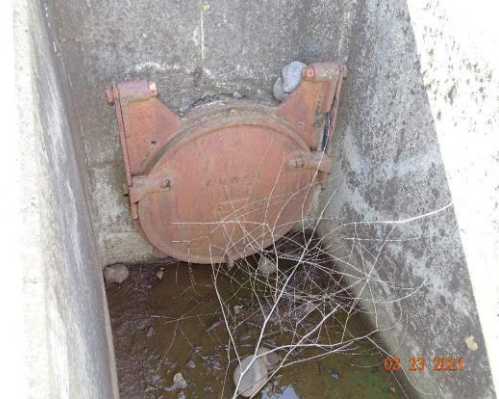
Photo 3 of 3 : UCIP\_FA\_2024\_67304\_99520.jpg

Water-Side: Headwall and flap gate at levee toe

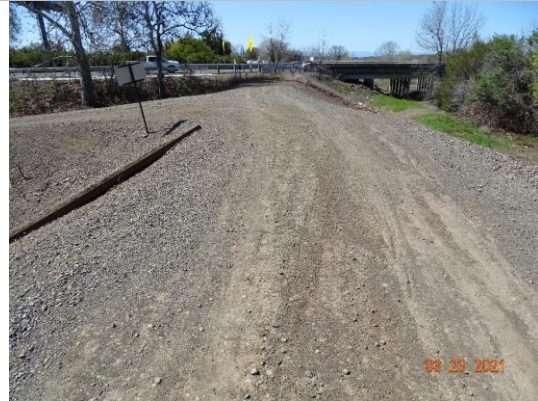
Photo 1 of 3 : UCIP\_FA\_2024\_77890\_99521.jpg

Comment Code						
Inspector Comment						
DS_ID:19235 FS_ID:77890 EP_NO: N/A Repair Type: Non-Urgent EVAL Issue: Crossing Status: Found UCIP Comments: 12/19/2022 Record updated from Urgent to Non-Urgent. Pipe has been CIPP-lined. LOF of crossing is less or equal to 4. Recommend next video inspection in 5 years. (O.Yakimov - DWR UCIP) 03/23/2021 Record updated from Non-Urgent to Urgent. DMP internal video inspection has found pipe integrity issues. LOF of crossing is between 5 and 6. Crossing will be monitored until funding becomes available to address the issues. No permit has been identified authorizing pipe. Recommend clearing debris from landside end of pipe. (O.Yakimov - DWR UCIP) 02/24/2014 Needs cleaning and clearing of debris. (P. Amatya - DWR UCIP) FIELD_STRUCT_DESC: 24-inch CIPP-lined corrugated metal gravity drainage pipe through the levee, 12.5 feet below the crown. Flap gate on the waterside (WS) end. Concrete U-shaped headwall on each end. Grouted riprap apron on the landside (LS) end. Grouted riprap spillway on the WS end. [Additional Reference(s): DWR Levee Log, 1992 (HLM 1.34). USACE Sacramento O&M Manual, Unit 504, May 1965, Revised 2 February 2011, (HLM 1.34), listed as 24-inch pipe. USACE As-Built Drawing No. 50-04-3685, Sheets 7 and 41, STA 358+10, 19 May 1965]. FS Date: 3/23/2021 3:56:40 PM

Top of Levee: View of levee crown looking downstream

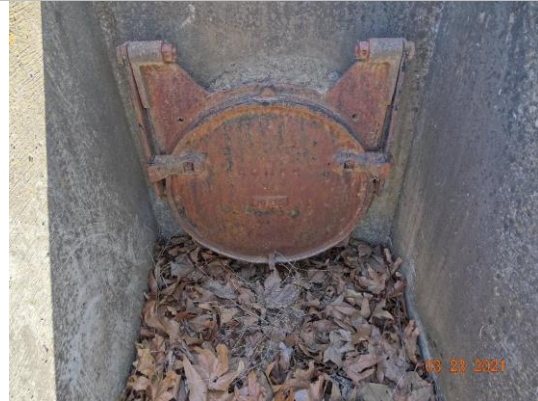
Photo 3 of 3 : UCIP\_FA\_2024\_77890\_99526.jpg

Water-Side: Headwall and flap gate at levee toe

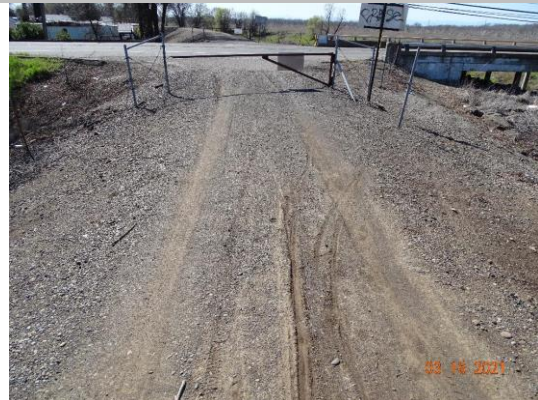
Photo 1 of 3 : UCIP\_FA\_2024\_67308\_99539.jpg

Top of Levee: View of levee crown looking downstream

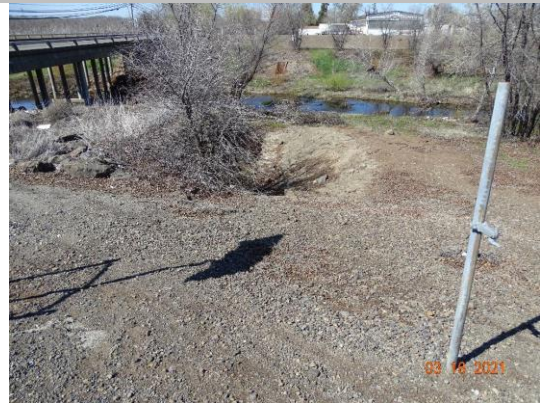
Photo 2 of 3 : UCIP\_FA\_2024\_67308\_99540.jpg

Water-Side: View of levee slope looking from crown

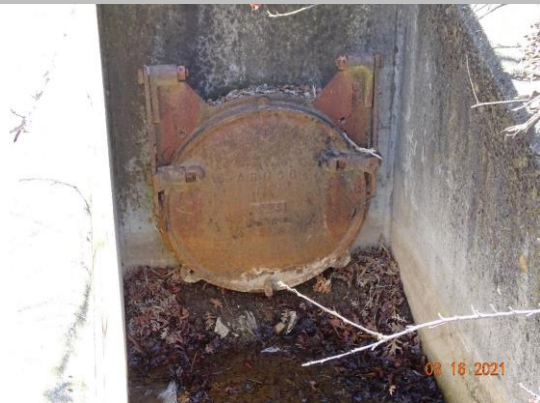
Photo 3 of 3 : UCIP\_FA\_2024\_67308\_99544.jpg

Water-Side: Headwall and flap gate at levee toe

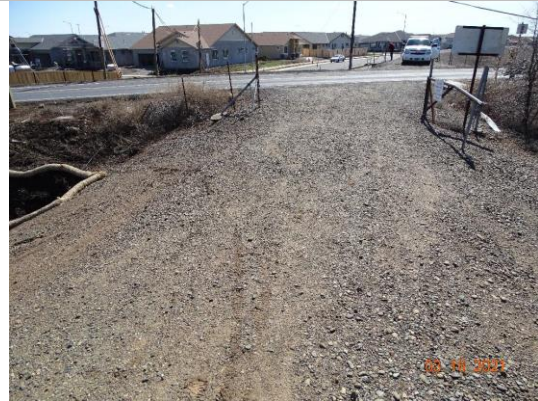
Photo 1 of 3 : UCIP\_FA\_2024\_67339\_99728.jpg

Comment Code						
Inspector Comment						
DS_ID:19238 FS_ID:67339 EP_NO: 12619A Repair Type: No Action Needed EVAL Issue: Crossing Status: Found UCIP Comments: 03/16/2021 Record updated from Non-Urgent to No Action Needed. Sleeved pipe has been removed from crossing. Enforcement case closed. DMP internal video inspection has not found pipe integrity issues. LOF of crossing is less or equal to 4. Recommend next video inspection in 5 years. (O.Yakimov - DWR UCIP) 11/03/2020 Field inspection revealed 15-inch HDPE pipe sleeved through 24-inch drainage pipe. Enforcement case No. 2020-15568 open for this crossing. (Oleg Yakimov - DWR UCIP) 02/24/2014 Inlet and spillway may need cleaning and clearing. (P. Amatya - DWR UCIP) FIELD_STRUCT_DESC: 24-inch corrugated metal gravity storm drainage pipe through the levee, 11 feet below the crown. Flap gate on the waterside (WS) end. Concrete U-shaped headwall on each end. Grouted riprap apron on the landside (LS) end. Grouted riprap spillway on the WS end. (Replacement an existing 24-inch storm drain inlet to the Mud Creek Diversion Channel with a 36-inch storm drain located approximately 500 feet upstream from Nord Highway authorized under Permit No. 12619, 1979 - Richard E. Vermillion). (Time extension to replace an existing 24-inch storm drain inlet to the Mud Creek Diversion Channel with a 36-inch storm drain located upstream from Nord Highway authorized under Permit No. 12619-A, 1980 - Richard E. Vermillion). The storm drain never got replaced. [Additional Reference(s): DWR Levee Log, 1992 (HLM 2.13), listed as 36-inch pipe. USACE Sacramento O&M Manual, Unit 504, May 1965, Revised 2 February 2011, (HLM 2.13), listed as 24-inch pipe. USACE As-Built Drawing No. 50-04-3685, Sheets 6 and 41, STA 317+50, 19 May 1965]. FS Date: 3/16/2021 10:57:49 AM

Top of Levee: View of levee crown looking downstream

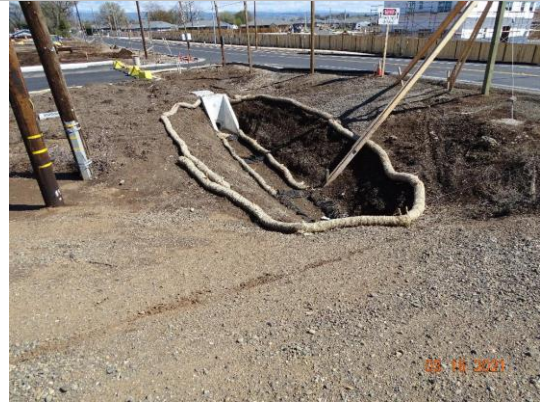
Photo 2 of 3 : UCIP\_FA\_2024\_67339\_99729.jpg

Land-Side: View of levee slope looking from crown. Newly constructed drainage on the berm

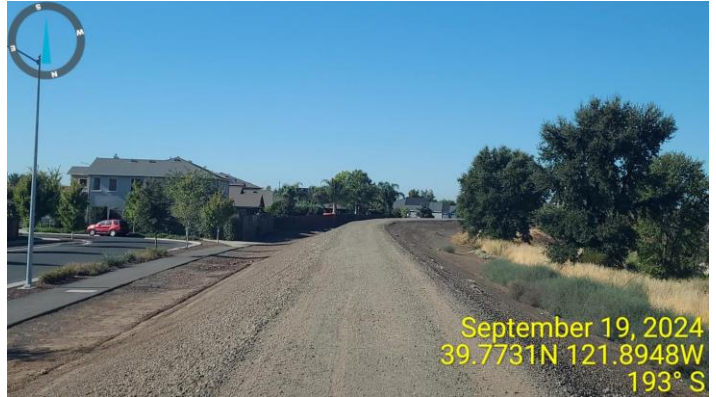
Photo 1 of 1 : FA\_2024\_NA0003\_65\_28\_20240924\_00069.jpg

LM Start	2.26	Rating **	A	Issue No.	28
LM End	2.26	Issue Type +	Ma	Location *	WS
Category	Earthen Levee			GPS Latitude/Longitude	
				Start	End
Item	Vegetation			39.773100°	39.773100°
				-121.894800°	-121.894800°
DWR ID	DWR_NA0003_02_f_2024_28				
Comment Code					
V1 : Control annual grass and weeds on the levee slopes and easements.					
Inspector Comment

View of good vegetation control along the levee slopes. Fall 2024.

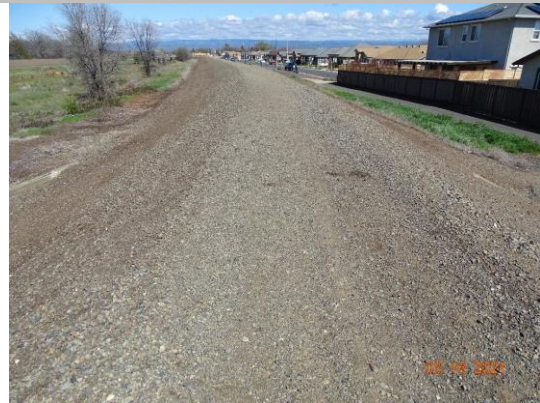
Photo 1 of 3 : UCIP\_FA\_2024\_67340\_99744.jpg

Comment Code						
Inspector Comment						
DS_ID:19239 FS_ID:67340 EP_NO: N/A Repair Type: Non-Urgent EVAL Issue: Crossing Status: Found UCIP Comments: 03/16/2021 Record remains Non-Urgent. No permit has been identified authorizing pipe. Debris around landside headwall has been cleared. DMP internal video inspection has not found pipe integrity issues. LOF of crossing is less or equal to 4. Recommend next video inspection in 5 years. (O.Yakimov - DWR UCIP) 02/24/2014 Debris in landside inlet area. Needs cleaning and clearing of debris. (P. Amatya - DWR UCIP) FIELD_STRUCT_DESC: 24-inch corrugated metal gravity drainage pipe through the levee, 10 feet below the crown. Flap gate on the waterside (WS) end. Concrete U-shaped headwall on each end. Grouted riprap apron on the landside (LS) end. Grouted riprap spillway on the WS end. [Additional Reference(s): DWR Levee Log, 1992 (HLM 2.44). USACE Sacramento O&M Manual, Unit 504, May 1965, Revised 2 February 2011, (HLM 2.44), listed as 24-inch pipe. USACE As-Built Drawing No. 50-04-3685, Sheets 6 and 41, STA 302+00, 19 May 1965]. FS Date: 3/16/2021 11:39:32 AM

Top of Levee: View of levee crown looking upstream

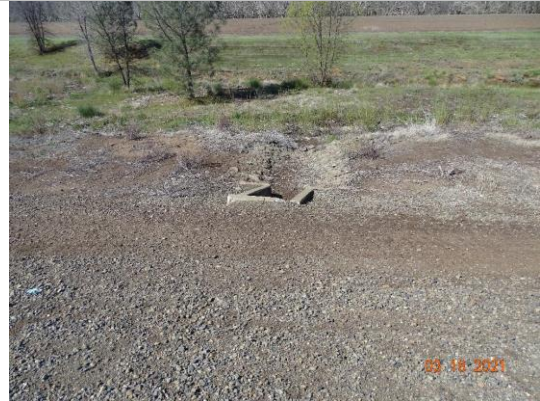
Photo 2 of 3 : UCIP\_FA\_2024\_67340\_99746.jpg

Water-Side: View of levee slope looking from crown

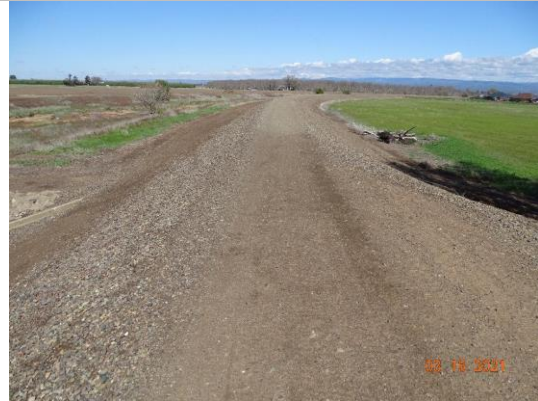
Photo 1 of 3 : UCIP\_FA\_2024\_67341\_99750.jpg

Comment Code					
Inspector Comment					
DS_ID:19240					
FS_ID:67341					
EP_NO: N/A					
Repair Type: Urgent					
EVAL Issue: 3a, Flood Risk					
Crossing Status: Found					
UCIP Comments: 03/16/2021 Record updated from Non-Urgent to Urgent. Flap gate not closing complitely. A gap between flap gate and pipe is visible. Adjustments and lubrication to flap gate hinges need to be done. DMP internal video inspection has not found pipe integrity issues. LOF of crossing is less or equal to 4. Recommend next video inspection in 5 years. (O.Yakimov - DWR UCIP)					
02/24/2014 Needs cleaning and clearing of debris. (P. Amatya - DWR UCIP)					
FIELD_STRUCT_DESC: 24-inch corrugated metal gravity drainage pipe through the levee, 10 feet below the crown. Flap gate on the waterside (WS) end. Concrete U-shaped headwall on each end. Grouted riprap apron on the landside (LS) end. Grouted riprap spillway on the WS end. [Additional Reference(s): DWR Levee Log, 1992 (HLM 2.84). USACE Sacramento O&M Manual, Unit 504, May 1965, Revised 2 February 2011, (HLM 2.86), listed as 24-inch pipe. USACE As-Built Drawing No. 50-04-3685, Sheets 6 and 41, STA 280+00, 19 May 1965].

Top of Levee: View of levee crown looking upstream

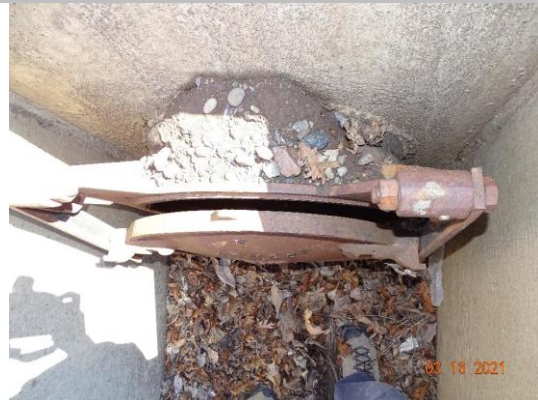
Photo 2 of 3 : UCIP\_FA\_2024\_67341\_99755.jpg

Water-Side: Gap visible between flap gate and pipe. Flap gate is unable to close tightly

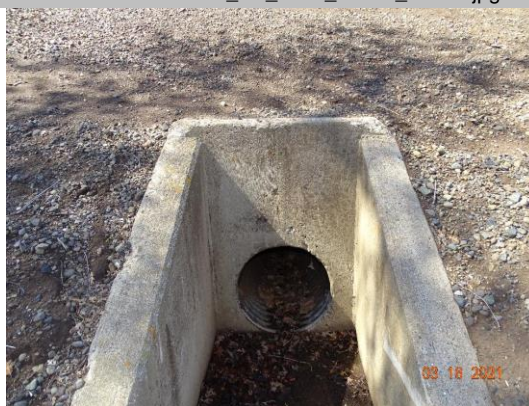
Photo 3 of 3 : UCIP\_FA\_2024\_67341\_99753.jpg

Land-Side: U-shaped headwall and pipe at levee toe

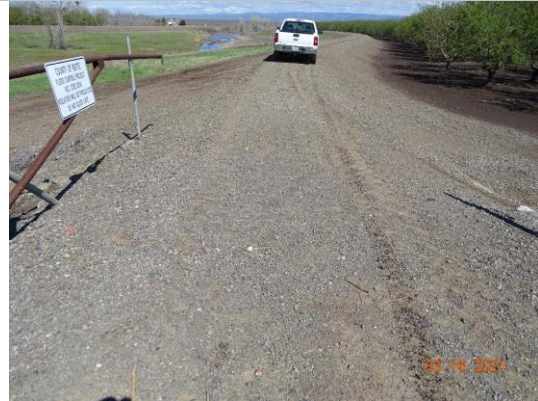
Photo 1 of 3 : UCIP\_FA\_2024\_67342\_99757.jpg

Comment Code					
Inspector Comment					
DS_ID:19241 FS_ID:67342 EP_NO: N/A Repair Type: Non-Urgent EVAL Issue: Crossing Status: Found UCIP Comments: 03/16/2021 Record remains Non-Urgent. No permit has been identified authorizing pipe. Debris has been cleared. DMP internal video inspection has not found pipe integrity issues. LOF of crossing is less or equal to 4. Recommend next video inspection in 5 years. (O.Yakimov - DWR UCIP) 02/24/2014 Needs cleaning and clearing of debris. (P. Amatya - DWR UCIP) FIELD_STRUCT_DESC: 24-inch corrugated metal gravity drainage pipe through the levee, 6.5 feet below the crown. Flap gate on the waterside (WS) end. Concrete U-shaped headwall on each end. Grouted riprap apron on the landside (LS) end. Grouted riprap spillway on the WS end. [Additional Reference(s): DWR Levee Log, 1992 (HLM 3.64). USACE Sacramento O&M Manual, Unit 504, May 1965, Revised 2 February 2011, (HLM 3.64), listed as 24-inch pipe. USACE As-Built Drawing No. 50-04-3685, Sheet 41, STA 239+80, 19 May 1965]. FS Date: 3/16/2021 12:48:10 PM

Top of Levee: View of levee crown looking upstream

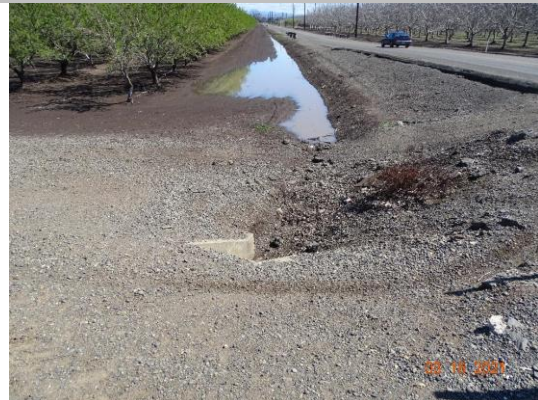
Photo 2 of 3 : UCIP\_FA\_2024\_67342\_99758.jpg

Land-Side: View of levee slope looking from crown

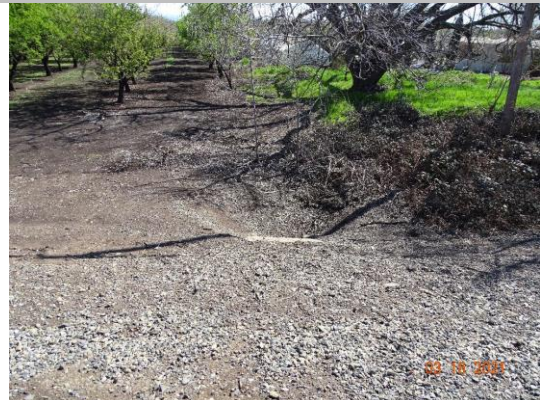
Photo 2 of 3 : UCIP\_FA\_2024\_67347\_99781.jpg

Land-Side: View of levee slope looking from crown

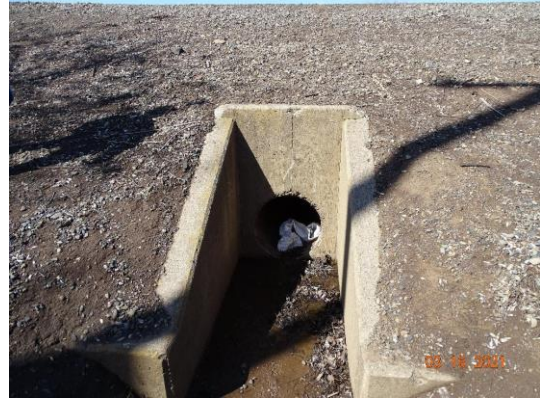
Photo 3 of 3 : UCIP\_FA\_2024\_67347\_99784.jpg

Land-Side: U-shaped headwall and pipe at levee toe

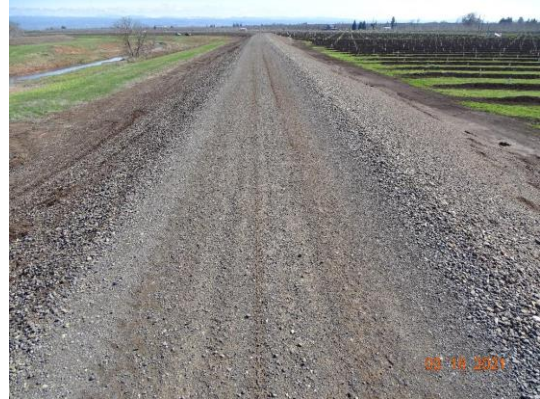
Photo 1 of 3 : UCIP\_FA\_2024\_77891\_99792.jpg

Comment Code						
Inspector Comment						
DS_ID:19247						
FS_ID:77891						
EP_NO: N/A						
Repair Type: Non-Urgent						
EVAL Issue:						
Crossing Status: Found						
UCIP Comments: 12/19/2022 Record updated from Urgent to Non-Urgent. Pipe has been CIPP-lined. LOF of crossing is less or equal to 4. Recommend next video inspection in 5 years. (O.Yakimov - DWR UCIP)						
03/16/2021 Record updated from Non-Urgent to Urgent. DMP internal video inspection has found pipe integrity issues. LOF of crossing is between 5 and 6. Crossing will be monitored until funding becomes available to address the issues. No permit has been identified authorizing pipe. Sediment at bottom of CMP is still present. (O.Yakimov - DWR UCIP)						
02/25/2014 Needs cleaning and clearing of debris. (P. Amatya - DWR UCIP)						
FIELD_STRUCT_DESC: 24-inch CIPP-lined corrugated metal gravity drainage pipe through the levee, 11.5 feet below the crown. Flap gate on the waterside (WS) end. Concrete U-shaped headwall on each end. Grouted riprap apron on the landside (LS) end. Grouted riprap spillway on the WS end. [Additional Reference(s): DWR Levee Log, 1992 (HLM 5.83). USACE Sacramento O&M Manual, Unit 504, May 1965, Revised 2 February 2011, (HLM 5.83), listed as 24-inch pipe. USACE As-Built Drawing No. 50-04-3685, Sheets 3 and 41, STA 134+60, 19 May 1965]. FS Date: 3/16/2021 3:59:32 PM

Top of Levee: View of levee crown looking upstream

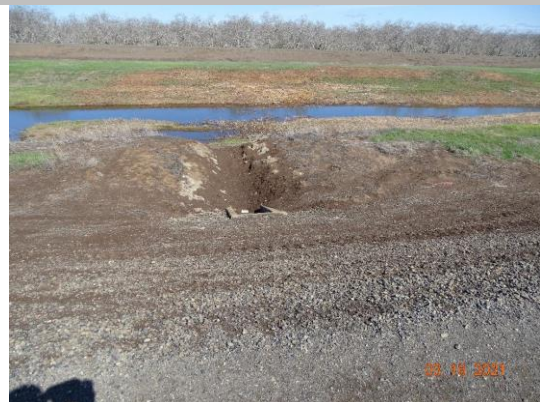
Photo 2 of 3 : UCIP\_FA\_2024\_77891\_99793.jpg

Water-Side: View of levee slope looking from crown

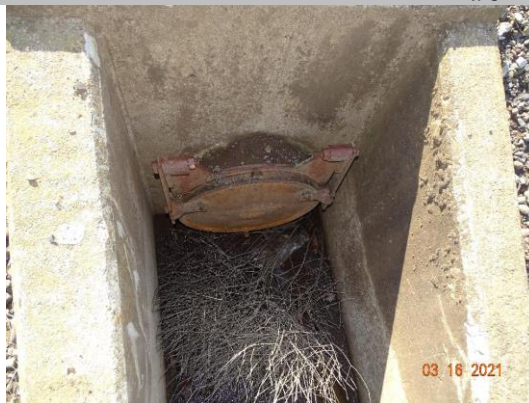
Photo 3 of 3 : UCIP\_FA\_2024\_77891\_99795.jpg

Water-Side: Headwall and flap gate at levee toe

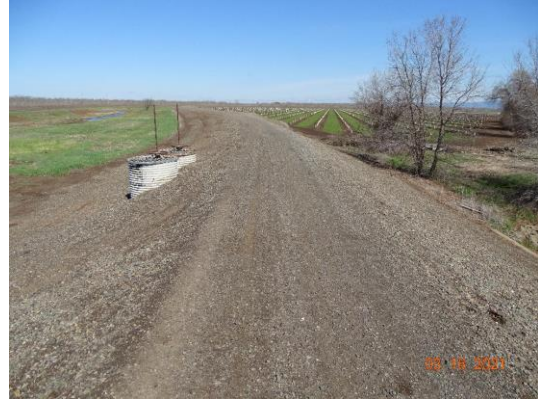
Photo 1 of 3 : UCIP\_FA\_2024\_67351\_99802.jpg

Comment Code						
Inspector Comment						
DS_ID:19248 FS_ID:67351 EP_NO: N/A Repair Type: No Action Needed EVAL Issue: Crossing Status: Found UCIP Comments: 09/15/2023 Record updated from Non-Urgent to No Action Needed. Pipe was CIPP lined. DMP internal video inspection has found none or minor pipe defects. Recommend next video inspection in 5 years. (O. Yakimov - DWR UCIP) 03/16/2021 Record remains Non-Urgent. DMP internal video inspection has found pipe integrity issues. LOF of crossing is between 4.1 and 5. Crossing will be monitored until funding becomes available for rehabilitation. No permit has been identified authorizing pipe. Debris has been cleared. (O.Yakimov - DWR UCIP) 02/25/2014 Needs cleaning and clearing of debris. (P. Amatya - DWR UCIP) FIELD_STRUCT_DESC: [Channel Slough Drainage Structure] 1 of 2: 42-inch CIPP-lined corrugated metal gravity drainage pipe through the levee, 16 feet below the crown. Flap gate on the waterside (WS) end. Slide gate in a corrugated metal pipe (CMP) riser on the WS slope. Concrete U-shaped headwall on each end. Grouted riprap apron and rock revetment on the landside (LS) end. [Additional Reference(s): DWR Levee Log, 1992 (HLM 6.30). USACE Sacramento O&M Manual, Unit 504, May 1965, Revised 2 February 2011, (HLM 6.30), listed as 42-inch pipe]. FS Date: 3/16/2021 11:45:20 AM

Top of Levee: View of levee crown looking upstream

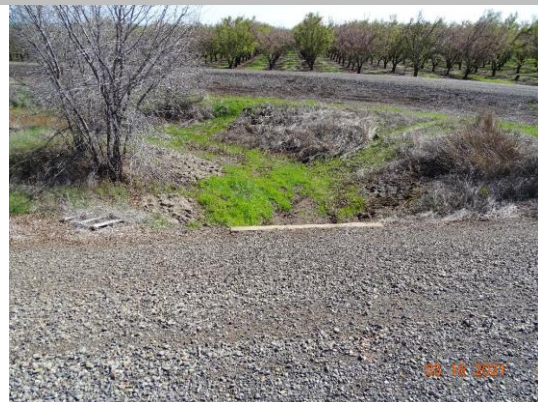
Photo 2 of 3 : UCIP\_FA\_2024\_67351\_99800.jpg

Land-Side: View of levee slope looking from crown

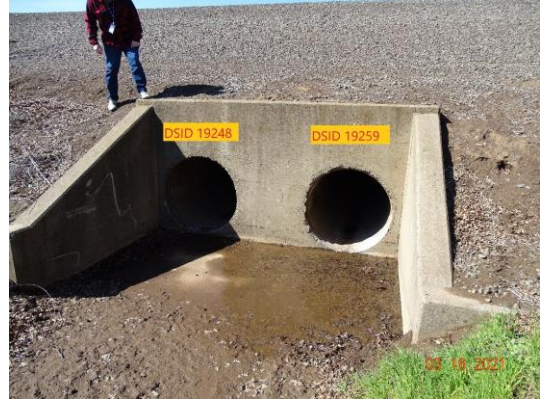
Photo 3 of 3 : UCIP\_FA\_2024\_67351\_99801.jpg

Land-Side: U-shaped headwall and pipe at levee toe

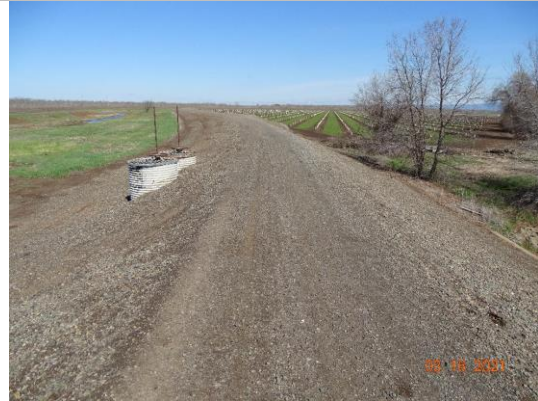
Photo 1 of 3 : UCIP\_FA\_2024\_67352\_99808.jpg

Comment Code						
Inspector Comment						
DS_ID:19259 FS_ID:67352 EP_NO: N/A Repair Type: No Action Needed EVAL Issue: Crossing Status: Found UCIP Comments: 09/15/2023 Record updated from Non-Urgent to No Action Needed. Pipe was CIPP lined. DMP internal video inspection has found none or minor pipe defects. Recommend next video inspection in 5 years. (O. Yakimov - DWR UCIP) 03/16/2021 Record remains Non-Urgent. No permit has been identified authorizing pipe. Debris has been cleared. DMP internal video inspection has found pipe integrity issues. LOF of crossing is greater than or equal to 4.1 and less than 5. Crossing will be monitored until funding becomes available for rehabilitation. (O.Yakimov - DWR UCIP) 02/25/2014 Needs cleaning and clearing of debris. (P. Amatya - DWR UCIP) FIELD_STRUCT_DESC: [Channel Slough Drainage Structure] 2 of 2: 42-inch CIPP-lined corrugated metal gravity drainage pipe through the levee, 16 feet below the crown. Flap gate on the waterside (WS) end. Slide gate in a corrugated metal pipe (CMP) riser on the WS slope. Concrete U-shaped headwall on each end. Grouted riprap apron and rock revetment on the landside (LS) end. [Additional Reference(s): DWR Levee Log, 1992 (HLM 6.30). USACE Sacramento O&M Manual, Unit 504, May 1965, Revised 2 February 2011, (HLM 6.30), listed as 42-inch pipe]. FS Date: 3/16/2021 11:47:02 AM

Top of Levee: View of levee crown looking upstream

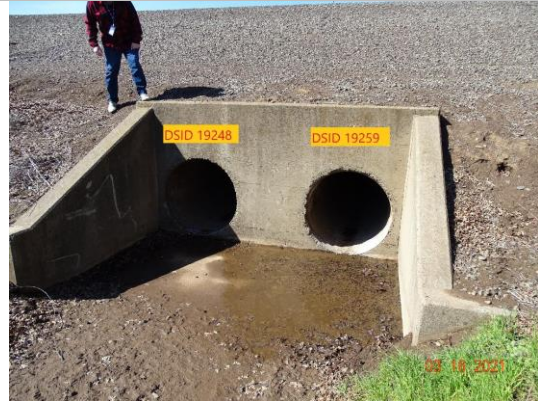
Photo 3 of 3 : UCIP\_FA\_2024\_67352\_99807.jpg

Land-Side: U-shaped headwall and pipe at levee toe

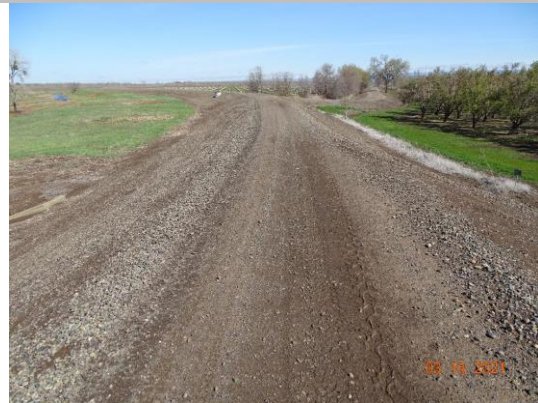
Photo 1 of 3 : UCIP\_FA\_2024\_67353\_99809.jpg

DS\_ID:19249  
FS\_ID:67353  
EP\_NO: N/A  
Repair Type: Urgent  
EVAL Issue: 1, Pipe Integrity  
Crossing Status: Found  
UCIP Comments: 03/16/2021 Record updated from Non-Urgent to Urgent. DMP internal video inspection has found pipe integrity issues. LOF of crossing is between 5 and 6. Crossing will be monitored until funding becomes available to address the issues. No permit has been identified authorizing pipe. Debris has been cleared. (O.Yakimov - DWR UCIP)  
02/25/2014 Needs cleaning and clearing of debris. (P. Amatya - DWR UCIP)  
FIELD\_STRUCT\_DESC: 24-inch corrugated metal gravity drainage pipe through the levee, 12 feet below the crown. Flap gate on the waterside (WS) end. Concrete U-shaped headwall on each end. Grouted riprap apron on the landside (LS) end. Grouted riprap spillway on the WS end. [Additional Reference(s): DWR Levee Log, 1992 (HLM 6.35). USACE Sacramento O&M Manual, Unit 504, May 1965, Revised 2 February 2011, (HLM 6.35), listed as 24-inch pipe. USACE As-Built Drawing No. 50-04-3685, Sheets 3 and 41, STA 107+10, 19 May 1965].

Top of Levee: View of levee crown looking upstream

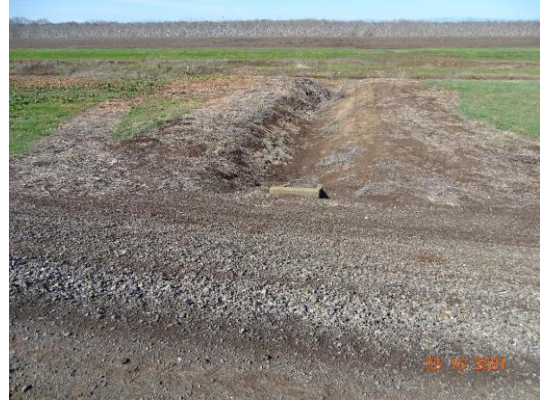
Photo 2 of 3 : UCIP\_FA\_2024\_67353\_99810.jpg

Water-Side: View of levee slope looking from crown

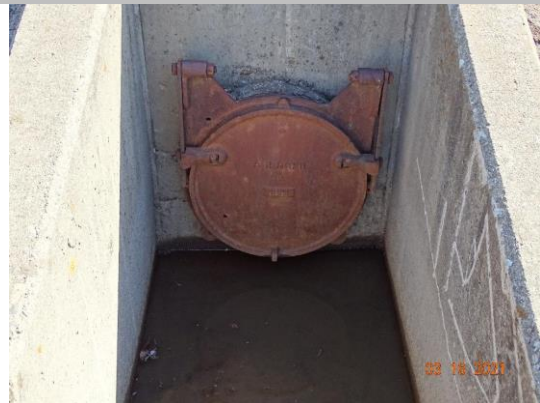
Photo 3 of 3 : UCIP\_FA\_2024\_67353\_99814.jpg

Water-Side: Headwall and flap gate at levee toe

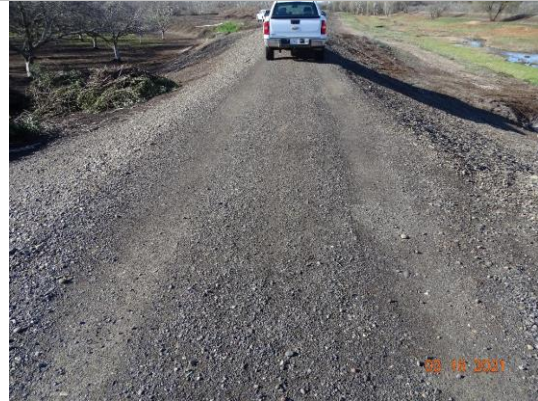
Photo 1 of 3 : UCIP\_FA\_2024\_77892\_99827.jpg

Comment Code						
Inspector Comment						
DS_ID:19251 FS_ID:77892 EP_NO: N/A Repair Type: Non-Urgent EVAL Issue: Crossing Status: Found UCIP Comments: 12/19/2022 Record updated from Urgent to Non-Urgent. Pipe has been CIPP-lined. LOF of crossing is less or equal to 4. Recommend next video inspection in 5 years. (O.Yakimov - DWR UCIP) 03/16/2021 Record updated from Non-Urgent to Urgent. DMP internal video inspection has found pipe integrity issues. LOF of crossing is between 5 and 6. Crossing will be monitored until funding becomes available to address the issues. No permit has been identified authorizing pipe. Debris has been cleared. (O.Yakimov - DWR UCIP) 02/25/2014 Needs cleaning and clearing of debris. (P. Amatya - DWR UCIP) FIELD_STRUCT_DESC: 24-inch CIPP-lined corrugated metal gravity drainage pipe through the levee, 15.5 feet below the crown. Flap gate on the waterside (WS) end. Concrete U-shaped headwall on each end. Grouted riprap apron on the landside (LS) end. Grouted riprap spillway on the WS end. Pipe crossing levee at angle. [Additional Reference(s): DWR Levee Log, 1992 (HLM 6.65). USACE Sacramento O&M Manual, Unit 504, May 1965, Revised 2 February 2011, (HLM 6.65), listed as 24-inch pipe. USACE As-Built Drawing No. 50-04-3685, Sheet 41, STA 91+98, 19 May 1965]. FS Date: 3/16/2021 4:01:52 PM

Top of Levee: View of levee crown looking downstream

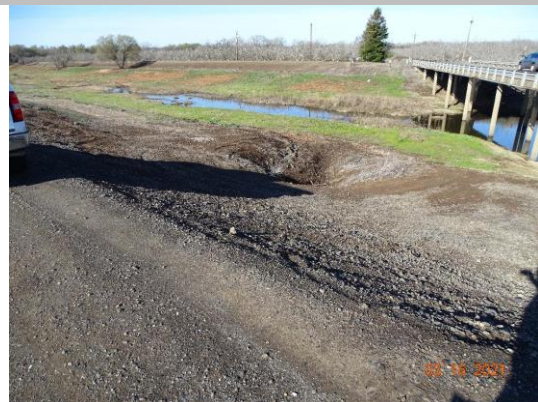
Photo 2 of 3 : UCIP\_FA\_2024\_77892\_99828.jpg

Water-Side: View of levee slope looking from crown

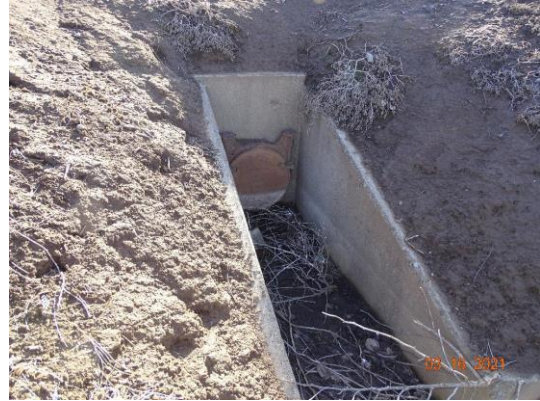
Photo 3 of 3 : UCIP\_FA\_2024\_77892\_99832.jpg

Water-Side: Headwall and flap gate at levee toe

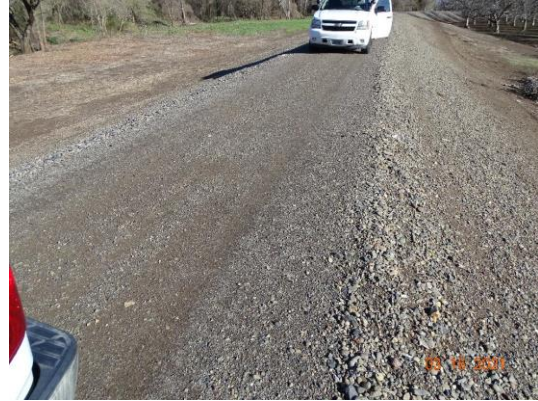
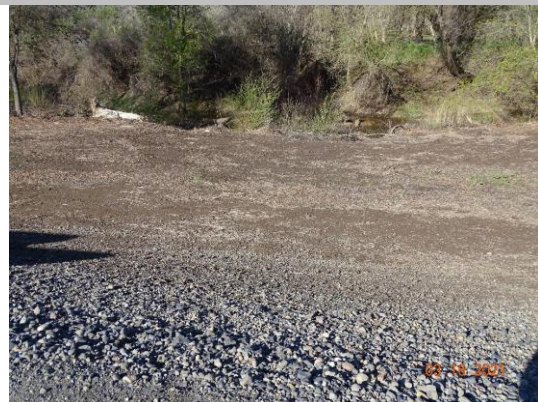
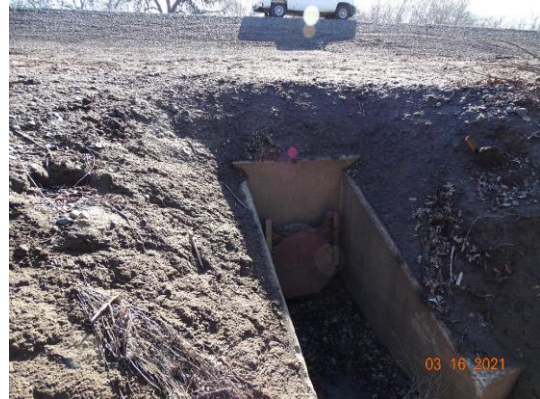
Comment Code						
Inspector Comment						
DS_ID:19252 FS_ID:77893 EP_NO: N/A Repair Type: Non-Urgent EVAL Issue: Crossing Status: Found UCIP Comments: 12/19/2022 Record updated from Urgent to Non-Urgent. Pipe has been CIPP-lined. LOF of crossing is less or equal to 4. Recommend next video inspection in 5 years. (O.Yakimov - DWR UCIP) 03/16/2021 Record updated from Non-Urgent to Urgent. DMP internal video inspection has found pipe integrity issues. LOF of crossing is between 5 and 6. Crossing will be monitored until funding becomes available to address the issues. No permit has been identified authorizing pipe. Sediment at the bottom of CMP needs claering. (O.Yakimov - DWR UCIP) 02/25/2014 Needs cleaning and clearing of debris. (P. Amatya - DWR UCIP) FIELD_STRUCT_DESC: 24-inch CIPP-lined corrugated metal gravity drainage pipe through the levee, 15 feet below the crown. Flap gate on the waterside (WS) end. Concrete U-shaped headwall on each end. Grouted riprap apron on the landside (LS) end. Grouted riprap spillway on the WS end. [Additional Reference(s): DWR Levee Log, 1992 (HLM 7.17). USACE Sacramento O&M Manual, Unit 504, May 1965, Revised 2 February 2011, (HLM 7.17), listed as 24-inch pipe. USACE As-Built Drawing No. 50-04-3684, Sheets 3 and 6, STA 64+80, 15 April 1963]. FS Date: 3/16/2021 4:02:29 PM

Top of Levee: View of levee crown looking upstream

Water-Side: View of levee slope looking from crown

Water-Side: Headwall and flap gate on levee berm

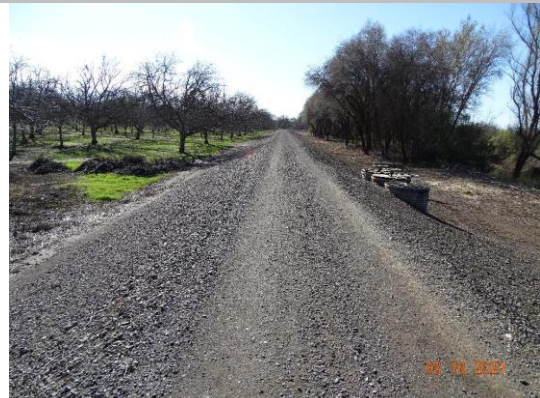
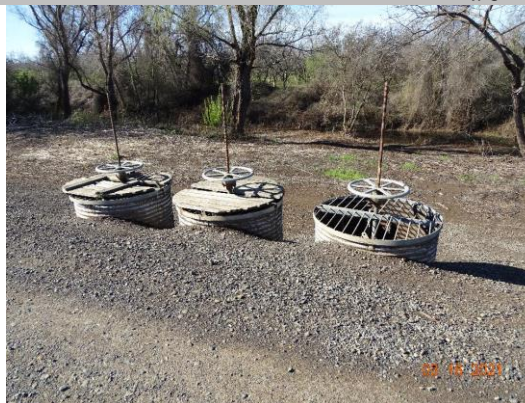
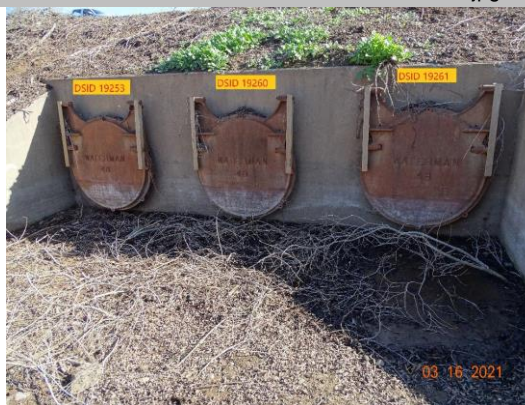
DS\_ID:19253  
FS\_ID:67359  
EP\_NO: N/A  
Repair Type: Non-Urgent  
EVAL Issue: 5, Pipe Damage  
Crossing Status: Found  
UCIP Comments: 09/23/2024 DMP internal video inspection has found moderate pipe defects. Crossing will be monitored until funding becomes available for rehabilitation. (O. Yakimov - DWR UCIP)  
03/16/2021 Record remains Non-Urgent. No permit has been identified authorizing pipe. Debris has been cleared. DMP internal video inspection has not found pipe integrity issues. LOF of crossing is less or equal to 4. Recommend next video inspection in 5 years. (O.Yakimov - DWR UCIP)  
02/25/2014 Slide gates in CMP risers on waterside shoulder. Needs cleaning and clearing of debris. (P. Amatya - DWR UCIP)  
FIELD\_STRUCT\_DESC: 1 of 3: 48-inch corrugated metal gravity drainage pipe through the levee, 18 feet below the crown. Flap gate on the waterside (WS) end. Slide gate in a corrugated metal pipe (CMP) riser on the WS shoulder. Concrete U-shaped headwall on each end. Grouted riprap apron on the landside (LS) end. Grouted riprap spillway on the WS end. [Additional Reference(s): DWR Levee Log, 1992 (HLM 7.46). USACE Sacramento O&M Manual, Unit 504, May 1965, Revised 2 February 2011, (HLM 7.46), listed as 48-inch pipe. USACE As-Built Drawing No. 50-04-3684, Sheets 3 and 6, STA 50+00, 15 April 1963].

Top of Levee: View of levee crown looking downstream

Water-Side: View of levee slope looking from crown. CMP riser with slide gate on levee shoulder

Water-Side: Headwall and flap gate at levee toe
