**Flood Control Project Maintenance  
Levee Inspections**

**Maintenance Issue Types Only, Levee Inspection Report By Mile - Fall 2024**

**Butte County Department of Public Works**

Waterway	Bank	Unit Miles	Inspection Start/End	Inspector
Unit No. 01 Mud Creek	Right	6.80	09/19/2024 09/19/2024	Makar Sokol

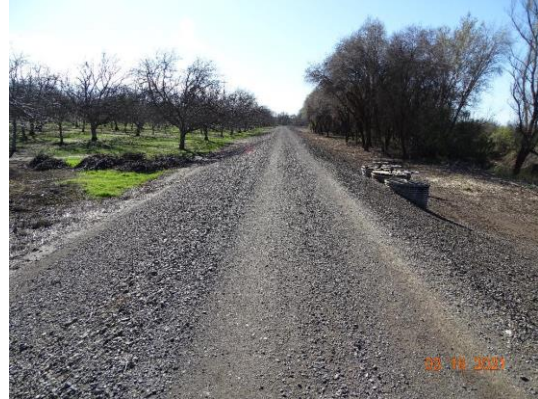
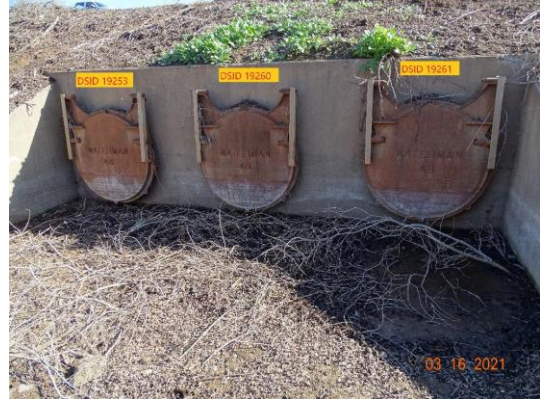
DS\_ID:19261  
FS\_ID:67361  
EP\_NO: N/A  
Repair Type: Non-Urgent  
EVAL Issue: 5, Pipe Damage  
Crossing Status: Found  
UCIP Comments: 09/23/2024 DMP internal video inspection has found moderate pipe defects. Crossing will be monitored until funding becomes available for rehabilitation. (O. Yakimov - DWR UCIP)  
03/16/2021 Record remains Non-Urgent. No permit has been identified authorizing pipe. Debris has been cleared. DMP internal video inspection has not found pipe integrity issues. LOF of crossing is less or equal to 4. Recommend next video inspection in 5 years. (O.Yakimov - DWR UCIP)  
02/25/2014 Slide gates in CMP risers on waterside shoulder. Needs cleaning and clearing on both pipe ends. (P. Amatyia - DWR UCIP)  
FIELD\_STRUCT\_DESC: 3 of 3: 48-inch corrugated metal gravity drainage pipe through the levee, 18 feet below the crown. Flap gate on the waterside (WS) end. Slide gate in a corrugated metal pipe (CMP) riser on the WS shoulder. Concrete U-shaped headwall on each end. Grouted riprap apron on the landside (LS) end. Grouted riprap spillway on the WS end. [Additional Reference(s): DWR Levee Log, 1992 (HLM 7.46). USACE Sacramento O&M Manual, Unit 504, May 1965, Revised 2 February 2011, (HLM 7.46), listed as 48-inch pipe. USACE As-Built Drawing No. 50-04-3684, Sheets 3 and 6, STA 50+00, 15 April 1963].

Top of Levee: View of levee crown looking downstream

Water-Side: Headwall and flap gate at levee toe

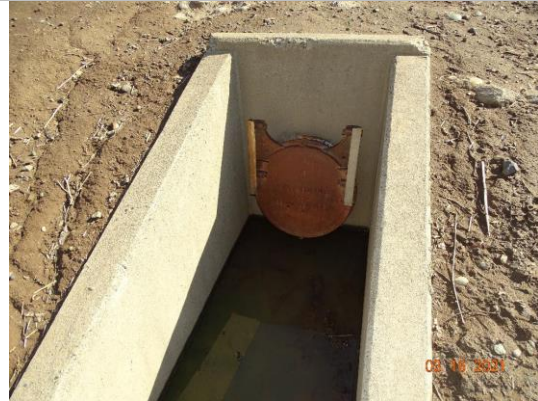
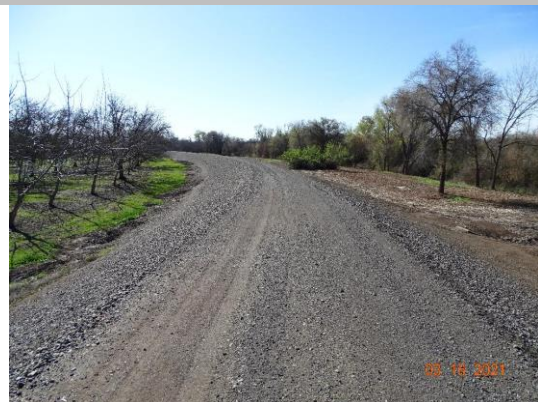
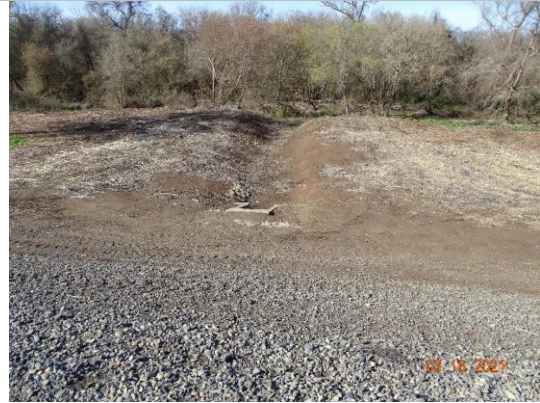
Comment Code						
Inspector Comment						
DS_ID:19254 FS_ID:67362 EP_NO: N/A Repair Type: No Action Needed EVAL Issue: Crossing Status: Found UCIP Comments: 09/15/2023 Record updated from Non-Urgent to No Action Needed. Pipe was CIPP lined. DMP internal video inspection has found none or minor pipe defects. Recommend next video inspection in 5 years. (O. Yakimov - DWR UCIP) 03/16/2021 Record remains Non-Urgent. DMP internal video inspection has found pipe integrity issues. LOF of crossing is greater than or equal to 4.1 and less than 5. Crossing will be monitored until funding becomes available for rehabilitation. No permit has been identified authorizing pipe. Debris has been cleared. (O.Yakimov - DWR UCIP) 02/25/2014 Debris in inlet pipe, needs cleaning and clearing. (P. Amatya - DWR UCIP) FIELD_STRUCT_DESC: 24-inch CIPP-lined corrugated metal gravity drainage pipe through the levee, 18 feet below the crown. Flap gate on the waterside (WS) end. Concrete U-shaped headwall on each end. Grouted riprap apron on the landside (LS) end. Grouted riprap spillway on the WS end. [Additional Reference(s): DWR Levee Log, 1992 (HLM 8.01). USACE Sacramento O&M Manual, Unit 504, May 1965, Revised 2 February 2011, (HLM 8.09), listed as 24-inch pipe. USACE As-Built Drawing No. 50-04-3684, footnote Sheet 2, Sheet 6, STA 21+23, 15 April 1963]. FS Date: 3/16/2021 3:19:02 PM

Water-Side: Headwall and flap gate at levee toe

Top of Levee: View of levee crown looking downstream

Water-Side: View of levee slope looking from crown

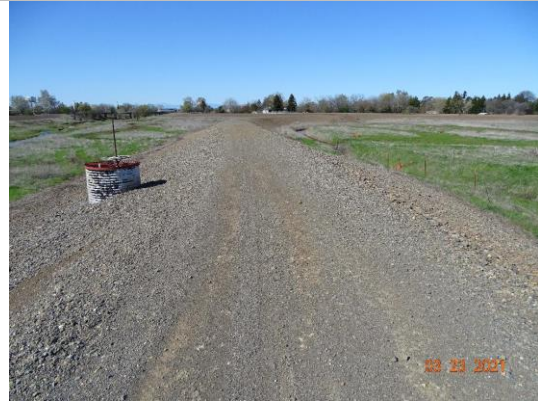
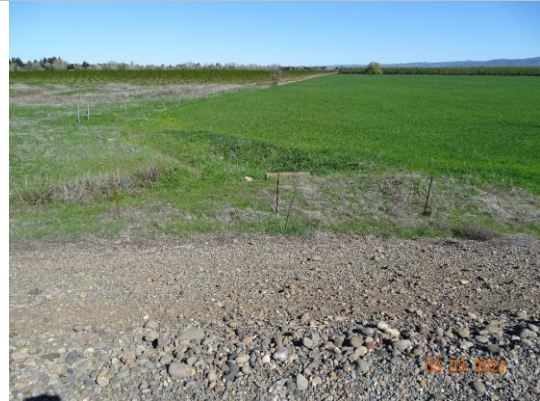
Comment Code					
Inspector Comment					
DS_ID:19262 FS_ID:77894 EP_NO: N/A Repair Type: Non-Urgent EVAL Issue: Crossing Status: Found UCIP Comments: 12/19/2022 Record updated from Urgent to Non-Urgent. Pipe has been CIPP-lined. LOF of crossing is less or equal to 4. Recommend next video inspection in 5 years. (O.Yakimov - DWR UCIP) 03/23/2021 Record updated from No Action Needed to Urgent. DMP internal video inspection has found pipe integrity issues. LOF of crossing is between 5 and 6. Crossing will be monitored until funding becomes available to address the issues. No permit has been identified authorizing pipe. (O.Yakimov - DWR UCIP) 05/16/2017 Crossing has been downgraded from Non-Urgent to No Action Needed. The flap gate appears to be in good working order based on the photos, and the small pile of debris not enough to warrant Non-Urgent rating. (K. Fazel - DWR UCIP) 03/11/2014 Slide gate in CMP riser on waterside The culvert was working during field inspection. (P. Amatya - DWR) FIELD_STRUCT_DESC: 42-inch CIPP-lined corrugated metal gravity drainage pipe through the levee, 14 feet below the crown. Flap gate on the waterside (WS) end. Slide gate in a corrugated metal pipe (CMP) riser on the WS slope. Concrete U-shaped headwall on each end. Grouted riprap apron on the landside (LS) end. Grouted riprap spillway on the WS end. [Additional Reference(s): DWR Levee Log, 1992 (HLM 0.09). USACE Sacramento O&M Manual, Unit 504, May 1965, Revised 2 February 2011, (HLM 0.09), listed as 42-inch pipe. USACE As-Built Drawing No. 50-04-3685, Sheets 7 and 40, STA 370+60, 19 May 1965]. FS Date: 3/23/2021 4:04:43 PM

Top of Levee: View of levee crown looking downstream

Land-Side: View of levee slope looking from crown

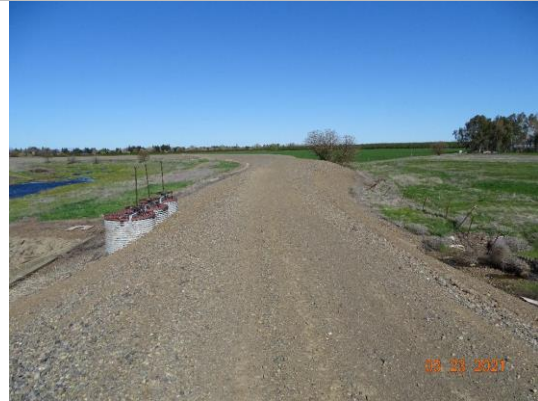
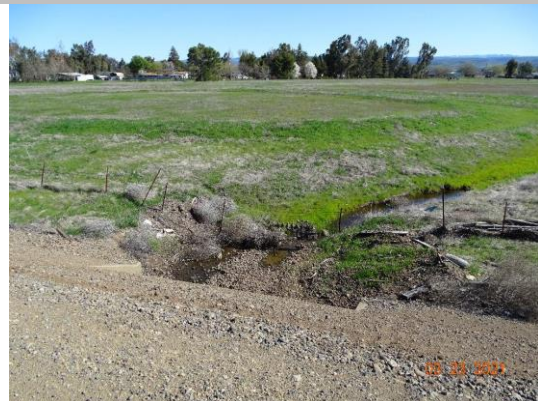
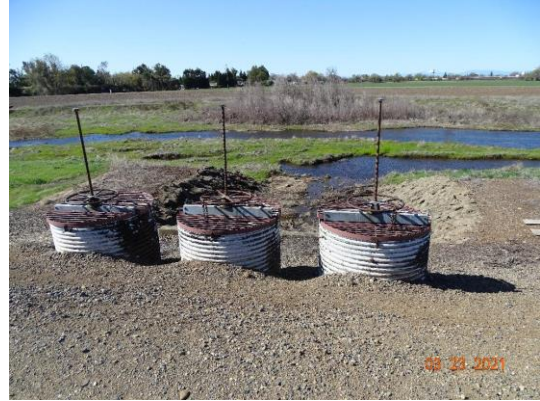
DS\_ID:19278  
FS\_ID:67669  
EP\_NO: N/A  
Repair Type: Non-Urgent  
EVAL Issue: 5, Pipe Damage  
Crossing Status: Found  
UCIP Comments: 09/23/2024 DMP internal video inspection has found moderate pipe defects. Crossing will be monitored until funding becomes available for rehabilitation. (O. Yakimov - DWR UCIP)  
03/23/2021 Record updated from No Action Needed to Non-Urgent. No permit has been identified authorizing pipe. DMP internal video inspection has not found pipe integrity issues. LOF of crossing is less or equal to 4. Recommend next video inspection in 5 years. (O.Yakimov - DWR UCIP)  
03/11/2014 Slide gate in CMP riser on waterside. The culvert was working during the field visit. (P. Amatya - DWR UCIP)  
FIELD\_STRUCT\_DESC: 1 of 3: 48-inch corrugated metal gravity drainage pipe through the levee, 11.7 feet below the crown. Slide gate in a riser well on the waterside (WS) slope. Concrete U-shaped headwall on each end. Flap gate on the WS end. Grouted riprap outlet channel on the WS. [Additional Reference(s): DWR Levee Log, 1992 (HLM 0.39). USACE Sacramento O&M Manual, Unit 504, May 1965, Revised 2 February 2011, (HLM 0.39), listed as 48-inch pipe. USACE As-Built Drawing No. 50-04-3685, Sheets 7 and 39, STA 385+90, 19 May 1965].

Top of Levee: View of levee crown looking downstream

Land-Side: View of levee slope looking from crown

Water-Side: View of levee slope looking from crown. CMP riser with slide gate on levee shoulder

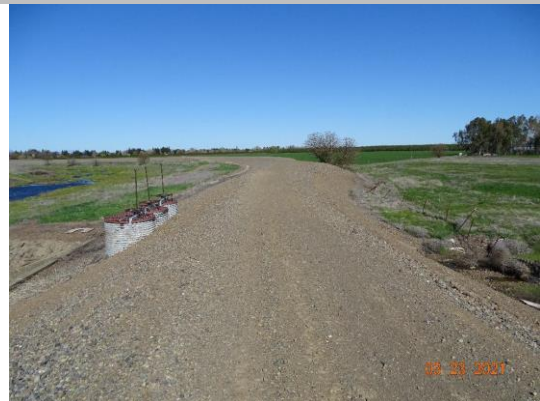
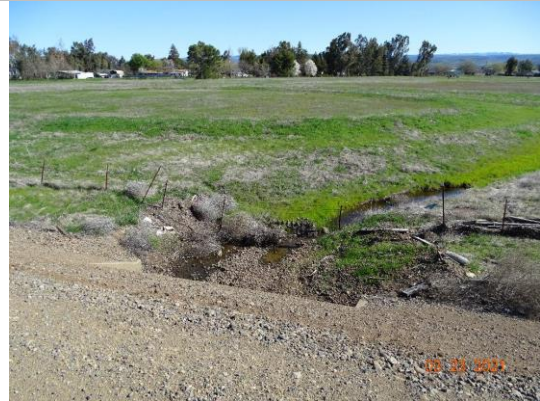
DS\_ID:19277  
FS\_ID:67670  
EP\_NO: N/A  
Repair Type: Non-Urgent  
EVAL Issue: 5, Pipe Damage  
Crossing Status: Found  
UCIP Comments: 09/23/2024 DMP internal video inspection has found moderate pipe defects. Crossing will be monitored until funding becomes available for rehabilitation. (O. Yakimov - DWR UCIP)  
03/23/2021 Record updated from No Action Needed to Non-Urgent. No permit has been identified authorizing pipe. DMP internal video inspection has not found pipe integrity issues. LOF of crossing is less or equal to 4. Recommend next video inspection in 5 years. (O.Yakimov - DWR UCIP)  
03/11/2014 Slide gate in CMP riser on watersideThe culvert was working during the field visit. (P. Amatya - DWR UCIP)  
FIELD\_STRUCT\_DESC: 2 of 3: 48-inch corrugated metal gravity drainage pipe through the levee, 11.7 feet below the crown. Slide gate in a riser well on the waterside (WS) slope. Concrete U-shaped headwall on each end. Flap gate on the WS end. Grouted riprap outlet channel on the WS. [Additional Reference(s): DWR Levee Log, 1992 (HLM 0.39). USACE Sacramento O&M Manual, Unit 504, May 1965, Revised 2 February 2011, (HLM 0.39), listed as 48-inch pipe. USACE As-Built Drawing No. 50-04-3685, Sheets 7 and 39, STA 385+90, 19 May 1965].

Top of Levee: View of levee crown looking downstream

Land-Side: View of levee slope looking from crown

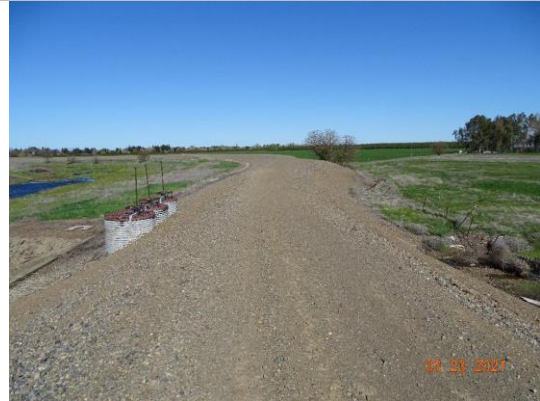
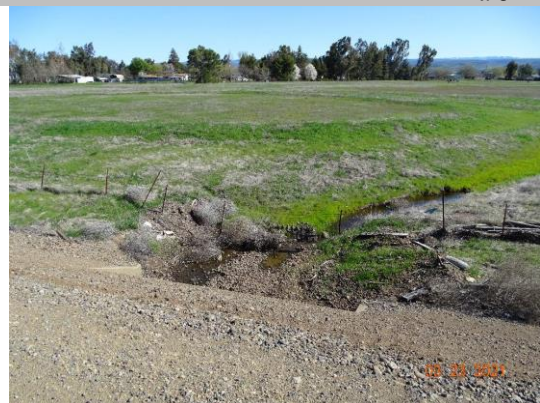
DS\_ID:19263  
FS\_ID:67671  
EP\_NO: N/A  
Repair Type: Non-Urgent  
EVAL Issue: 5, Pipe Damage  
Crossing Status: Found  
UCIP Comments: 09/23/2024 DMP internal video inspection has found moderate pipe defects. Crossing will be monitored until funding becomes available for rehabilitation. (O. Yakimov - DWR UCIP)  
03/23/2021 Record updated from No Action Needed to Non-Urgent. No permit has been identified authorizing pipe. DMP internal video inspection has not found pipe integrity issues. LOF of crossing is less or equal to 4. Recommend next video inspection in 5 years. (O.Yakimov - DWR UCIP)  
03/11/2014 Slide gate in CMP riser on watersideThe culvert was working during the field visit. (P. Amatya - DWR UCIP)  
FIELD\_STRUCT\_DESC: 3 of 3: 48-inch corrugated metal gravity drainage pipe through the levee, 11.7 feet below the crown. Slide gate in a riser well on the waterside (WS) slope. Concrete U-shaped headwall on each end. Flap gate on the WS end. Grouted riprap outlet channel on the WS. [Additional Reference(s): DWR Levee Log, 1992 (HLM 0.39). USACE Sacramento O&M Manual, Unit 504, May 1965, Revised 2 February 2011, (HLM 0.39), listed as 48-inch pipe. USACE As-Built Drawing No. 50-04-3685, Sheets 7 and 39, STA 385+90, 19 May 1965].

Top of Levee: View of levee crown looking downstream

Land-Side: View of levee slope looking from crown

Water-Side: View of levee slope looking from crown. CMP riser with slide gate on levee shoulder

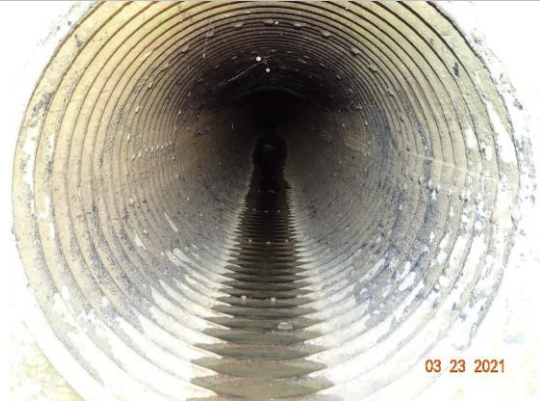
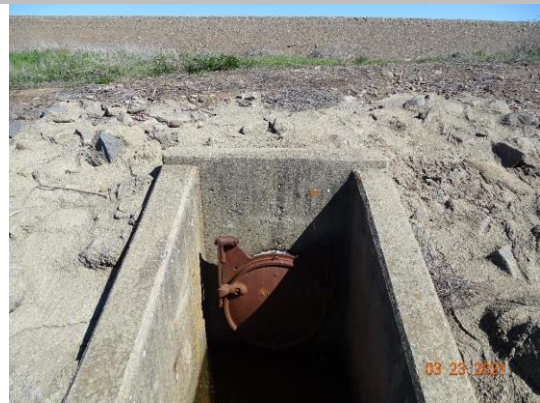
DS\_ID:19264  
FS\_ID:77895  
EP\_NO: N/A  
Repair Type: Non-Urgent  
EVAL Issue:  
Crossing Status: Found  
UCIP Comments: 12/19/2022 Record updated from Urgent to Non-Urgent. Pipe has been CIPP-lined. LOF of crossing is less or equal to 4. Recommend next video inspection in 5 years. (O.Yakimov - DWR UCIP).  
03/23/2021 Record updated from No Action Needed to Urgent. DMP internal video inspection has found pipe integrity issues. LOF of crossing is between 5 and 6. Crossing will be monitored until funding becomes available to address the issues. No permit has been identified authorizing pipe. (O.Yakimov - DWR UCIP)  
03/11/2014 The culvert was working during the field visit. (P. Amatya - DWR UCIP)  
FIELD\_STRUCT\_DESC: 24-inch CIPP-lined corrugated metal gravity drainage pipe through the levee, 11.7 feet below the crown. Flap gate on the waterside (WS) end. Concrete U-shaped headwall on each end. [Additional Reference(s): DWR Levee Log, 1992 (HLM 1.26). USACE Sacramento O&M Manual, Unit 504, May 1965, Revised 2 February 2011, (HLM 1.28), listed as 24-inch pipe. USACE As-Built Drawing No. 50-04-3685, Sheet 9, STA 431+50, 19 May 1965].

Top of Levee: View of levee crown looking upstream

Land-Side: View inside of pipe looking from landside end

Water-Side: Headwall and flap gate at levee toe

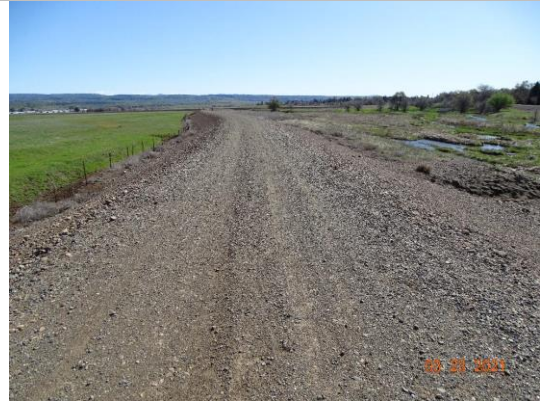
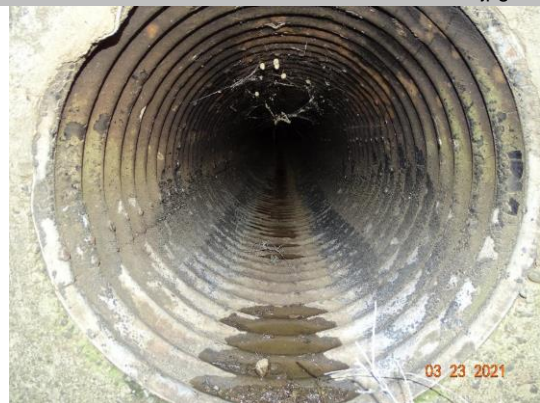
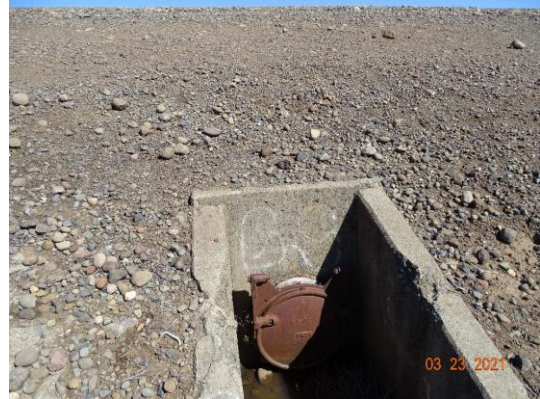
Comment Code						
Inspector Comment						
DS_ID:19265 FS_ID:67677 EP_NO: N/A Repair Type: No Action Needed EVAL Issue: Crossing Status: Found UCIP Comments: 09/15/2023 Record updated from Non-Urgent to No Action Needed. Pipe was CIPP lined. DMP internal video inspection has found none or minor pipe defects. Recommend next video inspection in 5 years. (O. Yakimov - DWR UCIP) 03/23/2021 Record updated from No Action Needed to Non-Urgent. DMP internal video inspection has found pipe integrity issues. LOF of crossing is greater than or equal to 4.1 and less than 5. Crossing will be monitored until funding becomes available for rehabilitation. No permit has been identified authorizing pipe. (O.Yakimov - DWR UCIP) 03/11/2014 Working during the field visit. (P. Amatya - DWR UCIP) FIELD_STRUCT_DESC: 24-inch CIPP-lined corrugated metal gravity drainage pipe through the levee, 11 feet below the crown. Flap gate on the waterside (WS) end. Concrete U-shaped headwall on each end. Grouted riprap apron on each end. [Additional Reference(s): DWR Levee Log, 1992 (HLM 1.52). USACE Sacramento O&M Manual, Unit 504, May 1965, Revised 2 February 2011, (HLM 1.53), listed as 24-inch pipe. USACE As-Built Drawing No. 50-04-3685, Sheet 9, STA 444+80, 19 May 1965]. FS Date: 3/23/2021 8:35:54 AM

Top of Levee: View of levee crown looking upstream

Land-Side: View inside of pipe looking from landside end

Water-Side: Levee slope, headwall and flap gate at levee toe

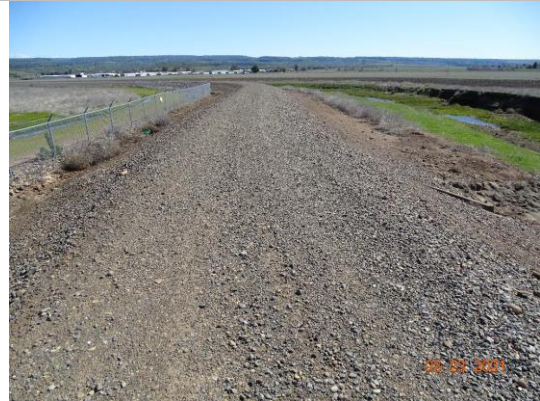
Photo 1 of 3 : UCIP\_FA\_2024\_67678\_100522.jpg

DS\_ID:19266  
FS\_ID:67678  
EP\_NO: N/A  
Repair Type: No Action Needed  
EVAL Issue:  
Crossing Status: Indicator Found  
UCIP Comments: 09/15/2023 Record updated from Non-Urgent to No Action Needed. Pipe was CIPP lined. DMP internal video inspection has found none or minor pipe defects. Recommend next video inspection in 5 years. (O. Yakimov - DWR UCIP)  
03/23/2021 Record remains Non-Urgent. DMP internal video inspection has found pipe integrity issues. LOF of crossing is greater than or equal to 4.1 and less than 5. Crossing will be monitored until funding becomes available for rehabilitation. No permit has been identified authorizing pipe. Coordinates of crossing have been updated. (O.Yakimov - DWR UCIP)  
03/11/2014 Needs location confirmation, GPS reading has not taken due to access problem. (P. Amatya - DWR UCIP)  
FIELD\_STRUCT\_DESC: 24-inch CIPP-lined corrugated metal gravity drainage pipe through the levee, 8 feet below the crown. Flap gate on the waterside (WS) end. Concrete U-shaped headwall on each end. Grouted riprap apron on the landside (LS) end. Grouted riprap spillway on the WS end. (4-inch PVC pipe through existing landside headwall authorized under Permit No. 17680, 2003 - City of Chico, Department of Public Works). [Additional Reference(s): DWR Levee Log, 1992 (HLM 2.00). USACE Sacramento O&M Manual, Unit 504, May 1965, Revised 2 February 2011, (HLM 2.00), listed as 24-inch pipe. USACE As-Built Drawing No. 50-04-3685, Sheet 10, STA 20+30, 19 May 1965].

Top of Levee: View of levee crown looking upstream

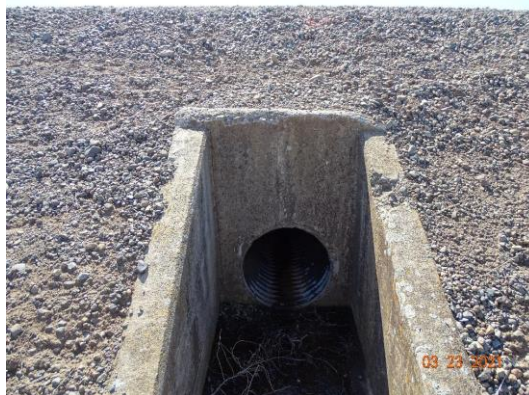
Photo 2 of 3 : UCIP\_FA\_2024\_67678\_100525.jpg

Land-Side: Levee slope, U-shaped headwall and pipe at levee toe

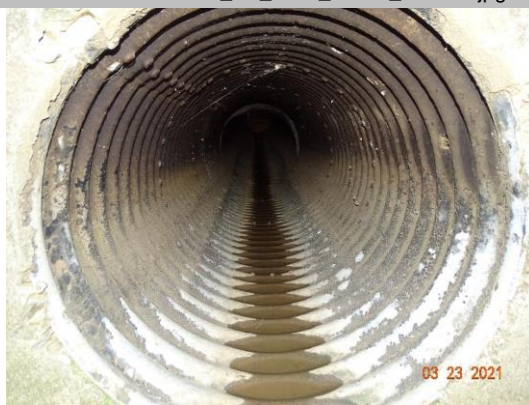
Photo 3 of 3 : UCIP\_FA\_2024\_67678\_100526.jpg

Land-Side: View inside of pipe looking from landside end

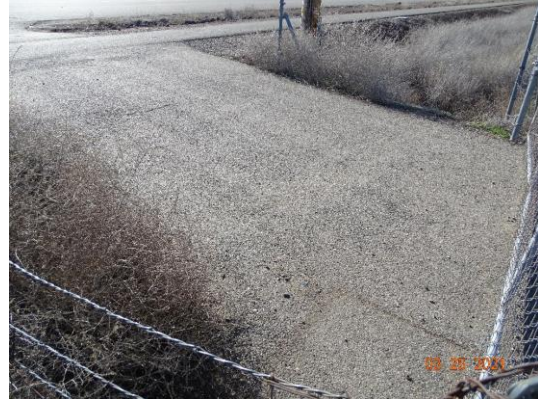
Photo 1 of 3 : UCIP\_FA\_2024\_84808\_100529.jpg

Comment Code					
Inspector Comment					
DS_ID:19267 FS_ID:84808 EP_NO: N/A Repair Type: Urgent EVAL Issue: 1, Pipe Integrity Crossing Status: Found UCIP Comments: 09/23/2024 Record updated from Non-Urgent to Urgent. DMP internal video inspection has found severe pipe defects. Crossing will be monitored until funding becomes available to address the issues. (O. Yakimov - DWR UCIP) 03/25/2021 Record remains Non-Urgent. No permit has been identified authorizing pipe. DMP internal video inspection has not found pipe integrity issues. LOF of crossing is less or equal to 4. Recommend next video inspection in 5 years. (O.Yakimov - DWR UCIP) 03/07/2014 Pipe is about 4 feet below the crown. Needs cleaning and clearing the culvert. (P. Amatya - DWR UCIP) FIELD_STRUCT_DESC: 24-inch corrugated metal gravity drainage pipe through the levee, 6 feet below the crown. Flap gate on the waterside (WS) end. Concrete U-shaped headwall on each end. [Additional Reference(s): DWR Levee Log, 1992 (HLM 2.23). USACE Sacramento O&M Manual, Unit 504, May 1965, Revised 2 February 2011, (HLM 2.23), listed as 24-inch pipe. USACE As-Built Drawing No. 50-04-3685, Sheet 10, STA 46+90, 19 May 1965]. FS Date: 3/25/2021 8:45:44 AM

Top of Levee: View of levee crown looking upstream

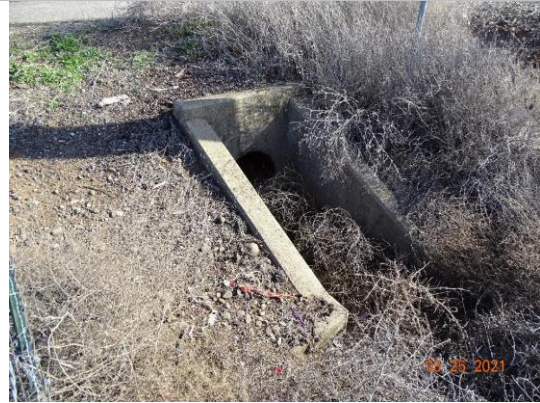
Photo 3 of 3 : UCIP\_FA\_2024\_84808\_100530.jpg

Land-Side: U-shaped headwall and pipe at levee toe

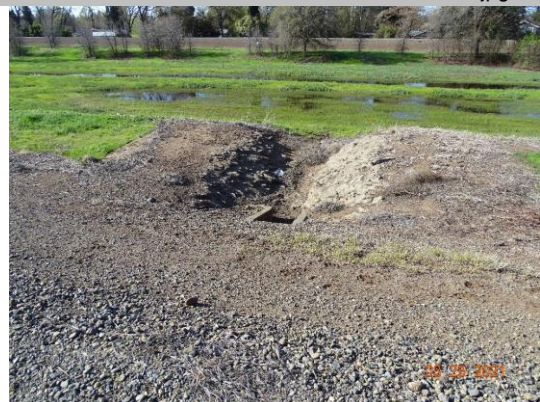
Photo 2 of 3 : UCIP\_FA\_2024\_67681\_100538.jpg

Water-Side: View of levee slope looking from crown

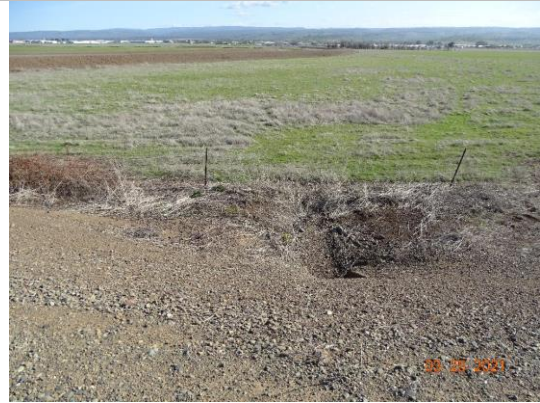
Photo 3 of 3 : UCIP\_FA\_2024\_67681\_100539.jpg

Land-Side: View of levee slope looking from crown

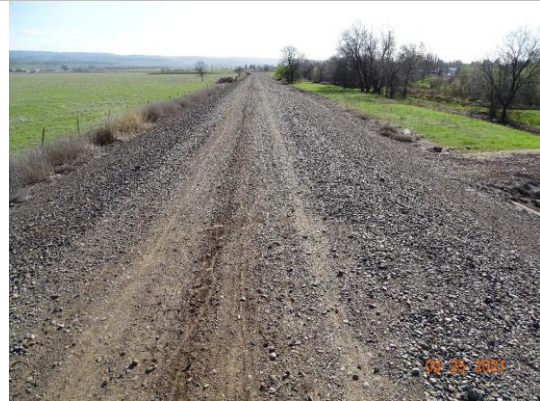
Photo 1 of 3 : UCIP\_FA\_2024\_67682\_100543.jpg

Comment Code						
Inspector Comment						
DS_ID:19270 FS_ID:67682 EP_NO: N/A Repair Type: Non-Urgent EVAL Issue: Crossing Status: Found UCIP Comments: 03/25/2021 Record is Non-Urgent. No permit has been identified authorizing pipe. DMP internal video inspection has not found pipe integrity issues. LOF of crossing is less or equal to 4. Recommend next video inspection in 5 years. (O.Yakimov - DWR UCIP)  FIELD_STRUCT_DESC: 24-inch corrugated metal gravity drainage pipe through the levee, 11 feet below the crown. Flap gate on the waterside (WS) end. Concrete U-shaped headwall on each end. Grouted riprap apron on the landside (LS) end. Grouted riprap spillway on the WS end. [Additional Reference(s): DWR Levee Log, 1992 (HLM 3.28). USACE Sacramento O&M Manual, Unit 504, May 1965, Revised 2 February 2011, (HLM 3.28), listed as 24-inch pipe. USACE As-Built Drawing No. 50-04-3685, Sheet 9, STA 462+10, 19 May 1965]]. FS Date: 3/25/2021 10:58:02 AM

Top of Levee: View of levee crown looking upstream

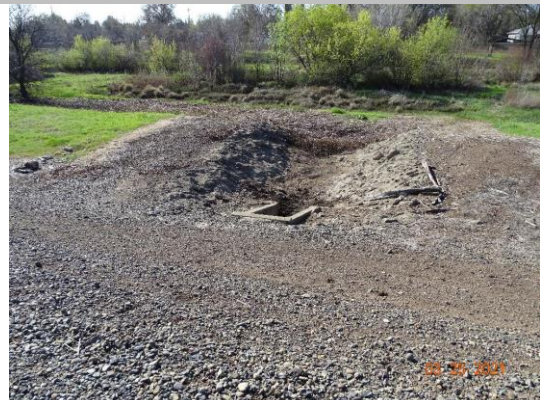
Photo 2 of 3 : UCIP\_FA\_2024\_67682\_100544.jpg

Water-Side: View of levee slope looking from crown

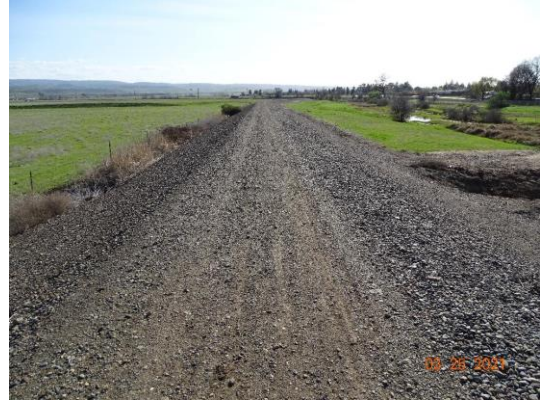
Photo 1 of 3 : UCIP\_FA\_2024\_67683\_100549.jpg

Comment Code					
Inspector Comment					
DS_ID:19271 FS_ID:67683 EP_NO: N/A Repair Type: Non-Urgent EVAL Issue: Crossing Status: Found UCIP Comments: 03/25/2021 Record remains Non-Urgent. Debris around culver has been cleared. No permit has been identified authorizing pipe. DMP internal video inspection has not found pipe integrity issues. LOF of crossing is less or equal to 4. Recommend next video inspection in 5 years. (O.Yakimov - DWR UCIP) 03/07/2014 Needs cleaning and clearing the culvert. (P. Amatya - DWR UCIP) FIELD_STRUCT_DESC: 24-inch corrugated metal gravity drainage pipe through the levee, 10.5 feet below the crown. Flap gate on the waterside (WS) end. Concrete U-shaped headwall on each end. Grouted riprap apron on the landside (LS) end. Grouted riprap spillway on the WS end. [Additional Reference(s): DWR Levee Log, 1992 (HLM 3.43). USACE Sacramento O&M Manual, Unit 504, May 1965, Revised 2 February 2011, (HLM 3.43), listed as 24-inch pipe. USACE As-Built Drawing No. 50-04-3685, Sheet 11, STA 470+20, 19 May 1965]. FS Date: 3/25/2021 11:00:29 AM

Top of Levee: View of levee crown looking upstream

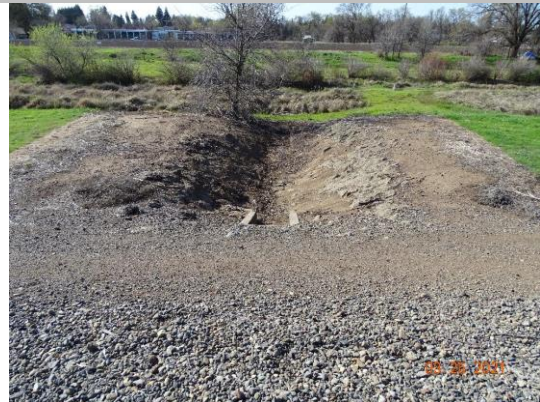
Photo 2 of 3 : UCIP\_FA\_2024\_67683\_100550.jpg

Water-Side: View of levee slope looking from crown

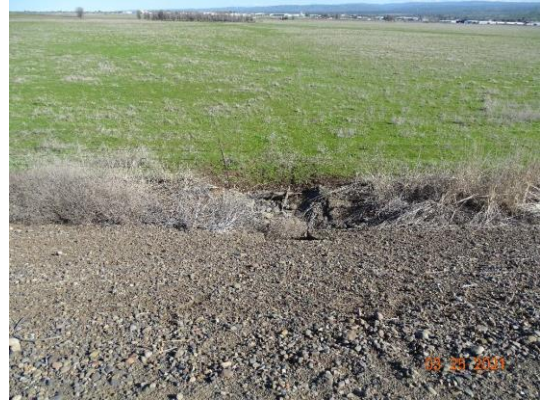
Photo 3 of 3 : UCIP\_FA\_2024\_67683\_100551.jpg

Land-Side: View of levee slope looking from crown

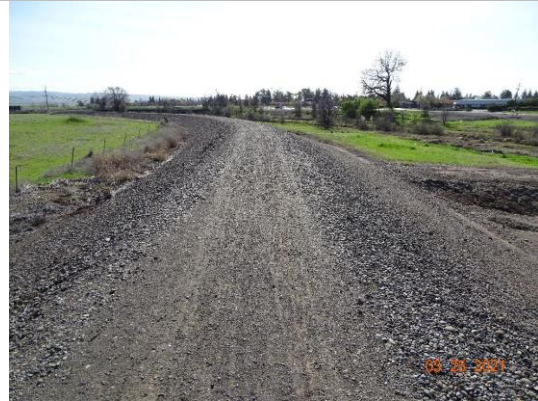
Photo 1 of 3 : UCIP\_FA\_2024\_67684\_100555.jpg

Comment Code						
Inspector Comment						
DS_ID:19272 FS_ID:67684 EP_NO: N/A Repair Type: Non-Urgent EVAL Issue: Crossing Status: Found UCIP Comments: 03/25/2021 Record remains Non-Urgent. Debris around culvert has been cleared. No permit has been identified authorizing pipe. DMP internal video inspection has not found pipe integrity issues. LOF of crossing is less or equal to 4. Recommend next video inspection in 5 years. (O.Yakimov - DWR UCIP) 03/07/2014 Needs cleaning and clearing the culvert. (P. Amatya - DWR UCIP) FIELD_STRUCT_DESC: 24-inch corrugated metal gravity drainage pipe through the levee, 9.5 feet below the crown. Flap gate on the waterside (WS) end. Concrete U-shaped headwall on each end. Grouted riprap apron on the landside (LS) end. Grouted riprap spillway on the WS end. [Additional Reference(s): DWR Levee Log, 1992 (HLM 3.59). USACE Sacramento O&M Manual, Unit 504, May 1965, Revised 2 February 2011, (HLM 3.59), listed as 24-inch pipe. USACE As-Built Drawing No. 50-04-3685, Sheet 11, STA 478+40, 19 May 1965]. FS Date: 3/25/2021 11:16:33 AM

Top of Levee: View of levee crown looking upstream

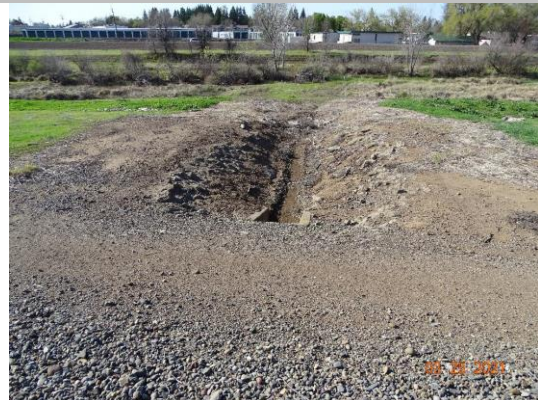
Photo 2 of 3 : UCIP\_FA\_2024\_67684\_100556.jpg

Water-Side: View of levee slope looking from crown

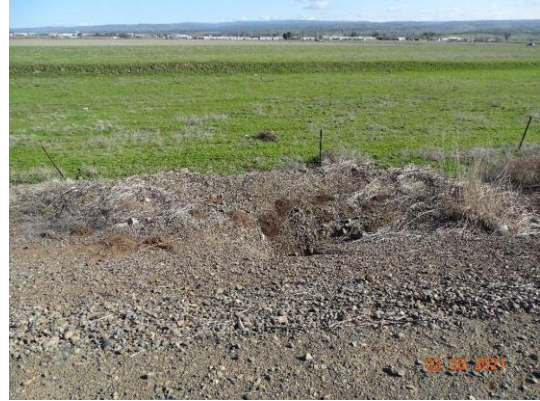
Photo 3 of 3 : UCIP\_FA\_2024\_67684\_100557.jpg

Land-Side: View of levee slope looking from crown

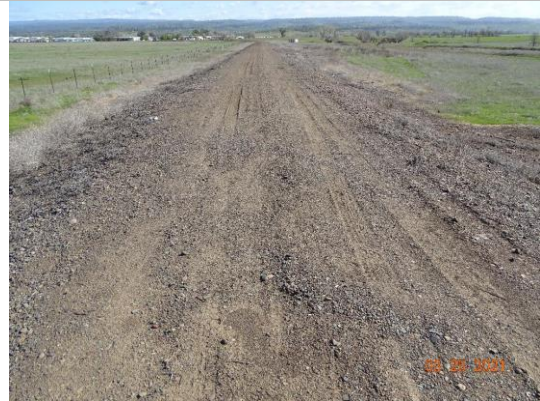
Photo 1 of 3 : UCIP\_FA\_2024\_67687\_100570.jpg

DS\_ID:19275  
FS\_ID:67687  
EP\_NO: N/A  
Repair Type: Non-Urgent  
EVAL Issue:  
Crossing Status: Found  
UCIP Comments: 03/25/2021 Record remains Non-Urgent. No permit has been identified authorizing pipe. DMP internal video inspection has not found pipe integrity issues. LOF of crossing is less or equal to 4. Recommend next video inspection in 5 years. (O.Yakimov - DWR UCIP)  
03/04/2014 The culvert was working during the field visit. Needs cleaning and clearing on both ends of the pipe. (P. Amatya - DWR UCIP)  
FIELD\_STRUCT\_DESC: 24-inch corrugated metal gravity drainage pipe through the levee, 7.5 feet below the crown. Flap gate on the waterside (WS) end. Concrete U-shaped headwall on each end. Grouted riprap apron on the landside (LS) end. Grouted riprap spillway on the WS end. (Installation of flap gate to existing 24-inch-diameter outfall pipe authorized under Permit No. 18106, 2006 - City of Chico). [Additional Reference(s): DWR Levee Log, 1992 (HLM 3.75). USACE Sacramento O&M Manual, Unit 504, May 1965, Revised 2 February 2011, (HLM 3.76), listed as 24-inch pipe. USACE As-Built Drawing No. 50-04-3685, Sheet 11, STA 486+62, 19 May 1965].

Top of Levee: View of levee crown looking upstream

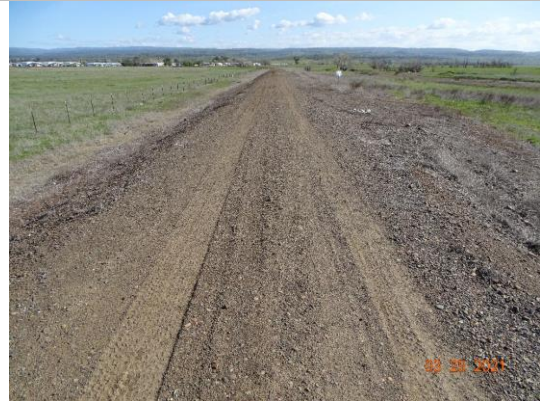
Photo 1 of 3 : UCIP\_FA\_2024\_67688\_100576.jpg

Comment Code					
Inspector Comment					
DS_ID:19274 FS_ID:67688 EP_NO: N/A Repair Type: Non-Urgent EVAL Issue: Crossing Status: Not Found UCIP Comments: 03/25/2021 Record is Non-Urgent. Crossing not found. Geophysical results did not confirm presence of pipe through levee. Record will remain in UCIP's inspection records until future Levee Improvement Project can confirm no crossing was found through the levee. No permit has been identified authorizing pipe. (O.Yakimov - DWR UCIP)					
FIELD_STRUCT_DESC: 24-inch corrugated metal gravity drainage pipe through the levee, 10 feet below the crown. Flap gate on the waterside (WS) end. Concrete U-shaped headwall on each end. Grouted riprap apron on the landside (LS) end. Grouted riprap spillway on the WS end. [Additional Reference(s): DWR Levee Log, 1992 (HLM 3.78). USACE Sacramento O&M Manual, Unit 504, May 1965, Revised 2 February 2011, (HLM 3.78), listed as 24-inch pipe. USACE As-Built Drawing No. 50-04-3685, Sheet 11, STA 488+20, 19 May 1965]. FS Date: 3/25/2021 1:25:15 PM

Top of Levee: View of levee crown looking upstream

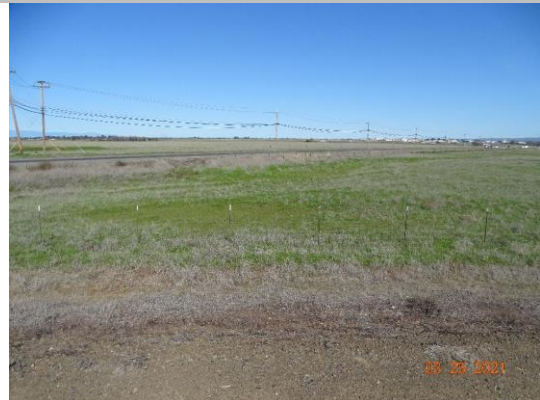
Photo 2 of 3 : UCIP\_FA\_2024\_67688\_100577.jpg

Land-Side: View of levee slope looking from crown

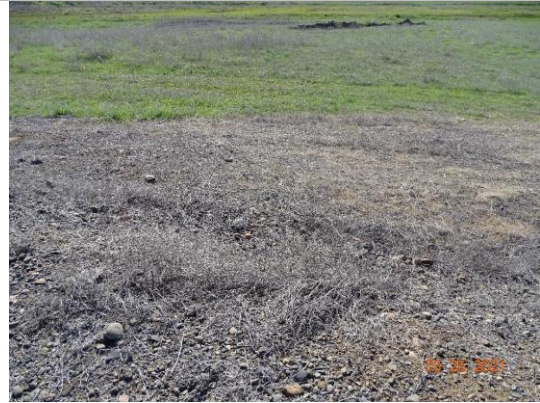
Photo 3 of 3 : UCIP\_FA\_2024\_67688\_100578.jpg

Water-Side: View of levee slope looking from crown

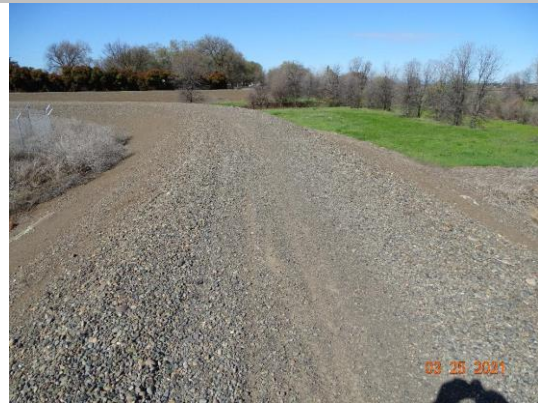
Photo 1 of 3 : UCIP\_FA\_2024\_67692\_100580.jpg

Comment Code						
Inspector Comment						
DS_ID:19279 FS_ID:67692 EP_NO: N/A Repair Type: Non-Urgent EVAL Issue: Crossing Status: Found UCIP Comments: 03/25/2021 Record remains Non-Urgent. No permit has been identified authorizing pipe. DMP internal video inspection has not found pipe integrity issues. LOF of crossing is less or equal to 4. Recommend next video inspection in 5 years. (O.Yakimov - DWR UCIP) 03/07/2014 Needs cleaning and clearing the culvert (P. Amatya - DWR UCIP) FIELD_STRUCT_DESC: 24-inch corrugated metal gravity drainage pipe through the levee, 10 feet below the crown. Flap gate on the waterside (WS) end. Concrete U-shaped headwall on each end. Grouted riprap apron on the landside (LS) end. Grouted riprap spillway on the WS end. [Additional Reference(s): DWR Levee Log, 1992 (HLM 0.28). USACE Sacramento O&M Manual, Unit 504, May 1965, Revised 2 February 2011, (HLM 0.28), listed as 24-inch pipe. USACE As-Built Drawing No. 50-04-3685, Sheets 11 and 41, STA 464+00, 19 May 1965]. FS Date: 3/25/2021 2:10:39 PM

Top of Levee: View of levee crown looking downstream

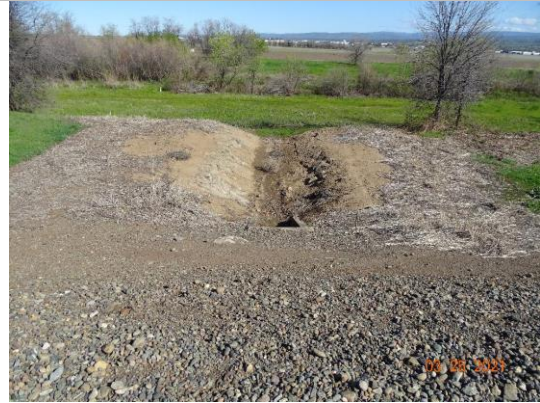
Photo 2 of 3 : UCIP\_FA\_2024\_67692\_100581.jpg

Water-Side: View of levee slope looking from crown

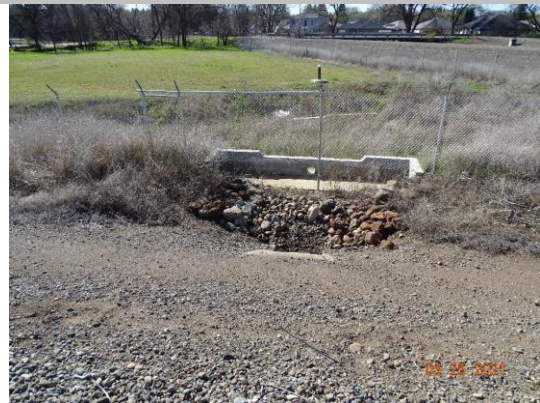
Photo 3 of 3 : UCIP\_FA\_2024\_67692\_100582.jpg

Land-Side: View of levee slope looking from crown

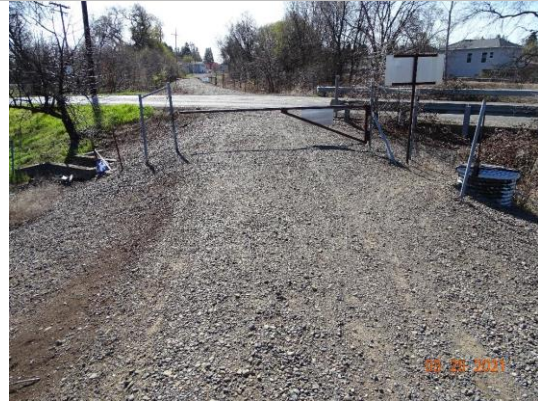
Photo 1 of 3 : UCIP\_FA\_2024\_67693\_100586.jpg

Comment Code						
Inspector Comment						
DS_ID:19280 FS_ID:67693 EP_NO: N/A Repair Type: Non-Urgent EVAL Issue: 5, Pipe Damage Crossing Status: Found UCIP Comments: 09/23/2024 DMP internal video inspection has found moderate pipe defects. Crossing will be monitored until funding becomes available for rehabilitation. (O. Yakimov - DWR UCIP) 03/25/2021 Record remains Non-Urgent. Debris around on inlet has been cleared. No permit has been identified authorizing pipe. DMP internal video inspection has not found pipe integrity issues. LOF of crossing is less or equal to 4. Recommend next video inspection in 5 years. (O.Yakimov - DWR UCIP) 03/07/2014 Slide gate in a CMP riser. Vegetation debris and mud on inlet box. Needs cleaning and clearing the culvert. (P. Amatya - DWR UCIP) FIELD_STRUCT_DESC: 24-inch corrugated metal gravity drainage pipe through the levee and under the channel, 9.5 feet below the crown. Slide gate in a corrugated metal pipe (CMP) riser on the waterside (WS) slope. Concrete U-shaped headwall on the landside (LS) end. [Additional Reference(s): DWR Levee Log, 1992 (HLM 0.34). USACE Sacramento O&M Manual, Unit 504, May 1965, Revised 2 February 2011, (HLM 0.34), listed as 24-inch pipe. USACE As-Built Drawing No. 50-04-3685, Sheet 11, between STA 2+20 and STA 3+20, 19 May 1965, shown as existing siphon through both levees and under channel]. FS Date: 3/25/2021 2:16:53 PM

Top of Levee: View of levee crown looking upstream

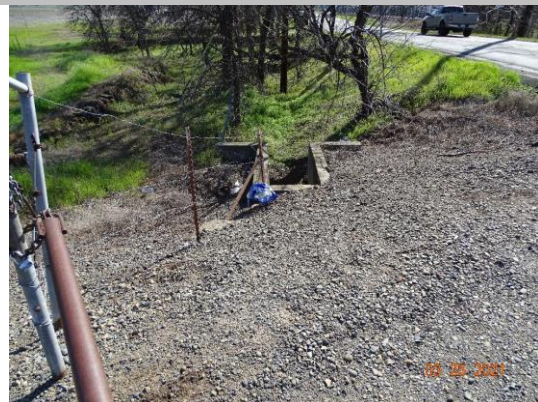
Photo 2 of 3 : UCIP\_FA\_2024\_67693\_100588.jpg

Land-Side: View of levee slope looking from crown

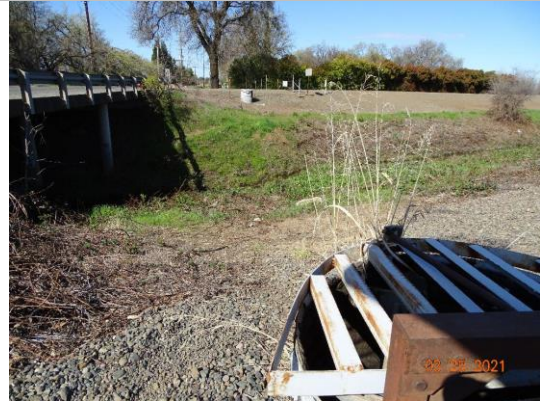
Photo 3 of 3 : UCIP\_FA\_2024\_67693\_100589.jpg

Water-Side: Detailed view of levee slope. Pipe outfall not visible on waterside. Crossing DSID 19288 on opposite side of levee

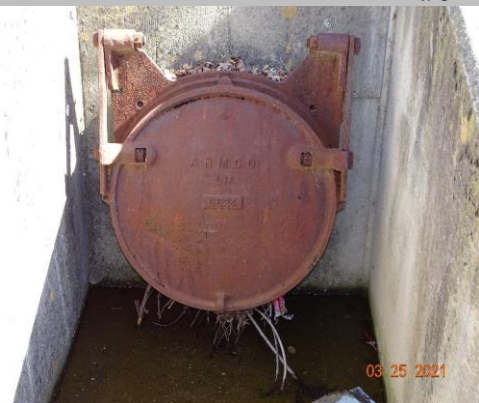
Photo 1 of 3 : UCIP\_FA\_2024\_67694\_100595.jpg

DS\_ID:19281  
FS\_ID:67694  
EP\_NO: N/A  
Repair Type: Urgent  
EVAL Issue: 3a, Flood Risk  
Crossing Status: Found  
UCIP Comments: 03/25/2021 Record updated from Non-Urgent to Urgent. Debris inside pipe holds flap gate from complete closing. Backflow may cause flood risk to landside. No permit has been identified authorizing pipe. DMP internal video inspection has not found pipe integrity issues. LOF of crossing is less or equal to 4. Recommend next video inspection in 5 years. (O.Yakimov - DWR UCIP)  
03/07/2014 Needs cleaning and clearing the culvert. (P. Amatya - DWR UCIP)  
FIELD\_STRUCT\_DESC: 24-inch corrugated metal gravity drainage pipe through the levee, 8 feet below the crown. Flap gate on the waterside (WS) end. Concrete U-shaped headwall on each end. Grouted riprap apron on the landside (LS) end. Grouted riprap spillway on the WS end. [Additional Reference(s): DWR Levee Log, 1992 (HLM 0.36). USACE Sacramento O&M Manual, Unit 504, May 1965, Revised 2 February 2011, (HLM 0.36), listed as 24-inch pipe. USACE As-Built Drawing No. 50-04-3685, Sheets 11 and 41, STA 4+20, 19 May 1965].

Water-Side: Headwall and flap gate at levee toe

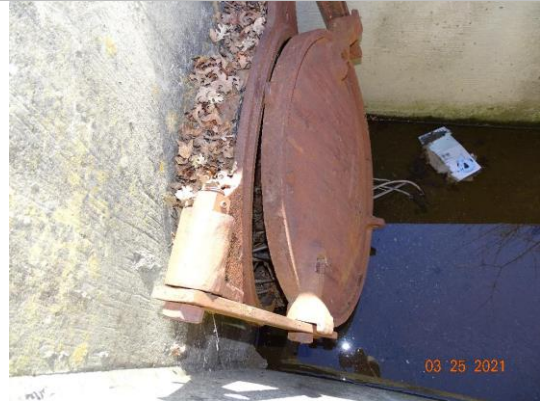
Photo 2 of 3 : UCIP\_FA\_2024\_67694\_100596.jpg

Water-Side: Debris inside of pipe blocks flap gate from complete closing

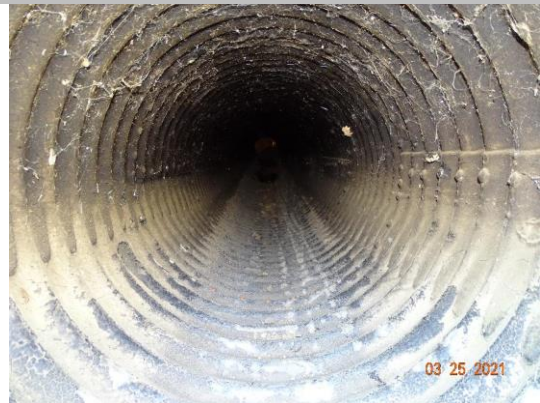
Photo 3 of 3 : UCIP\_FA\_2024\_67694\_100598.jpg

Land-Side: View inside of pipe looking from landside end

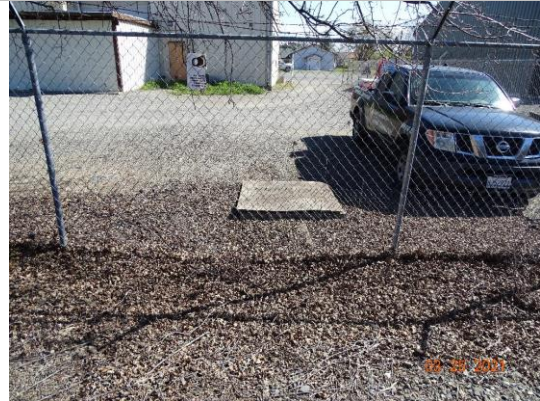
Photo 1 of 3 : UCIP\_FA\_2024\_67757\_100818.jpg

Comment Code						
Inspector Comment						
DS_ID:19283 FS_ID:67757 EP_NO: N/A Repair Type: Urgent EVAL Issue: 1, Pipe Integrity Crossing Status: Found UCIP Comments: 03/25/2021 Record updated from No Action Needed to Urgent. DMP internal video inspection has found severe pipe defects. Crossing will be monitored until funding becomes available to address the issues. (O.Yakimov - DWR UCIP) 03/07/2014 Concrete vault on landside. Not found- grouted apron on the landward end. (P. Amatya - DWR UCIP) FIELD_STRUCT_DESC: 18-inch corrugated metal gravity drainage pipe through the levee, 4 feet below the crown. Concrete drainage vault in parking space on landside, flap gate on waterside pipe end. Grouted riprap spillway on the waterside (WS) end. [Additional Reference(s): DWR Levee Log, 1992 (HLM 0.65). USACE Sacramento O&M Manual, Unit 504, May 1965, Revised 2 February 2011, (HLM 0.66), listed as 18-inch pipe. USACE As-Built Drawing No. 50-04-3685, Sheet 11, STA 25+30???, 19 May 1965]. FS Date: 3/25/2021 2:07:20 PM

Land-Side: Fence on levee berm. Storm drain manhole covered with plywood sheet on levee berm

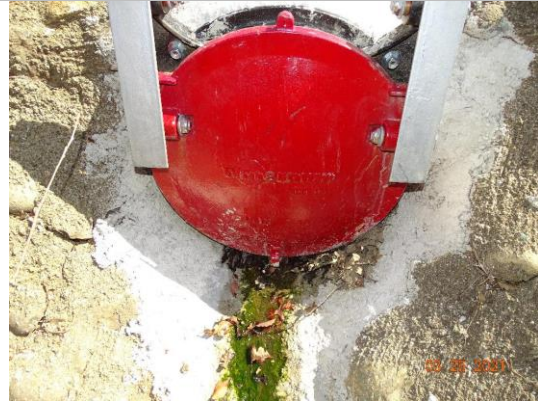
Photo 3 of 3 : UCIP\_FA\_2024\_67757\_100821.jpg

Water-Side: Close up view of flap gate on levee slope

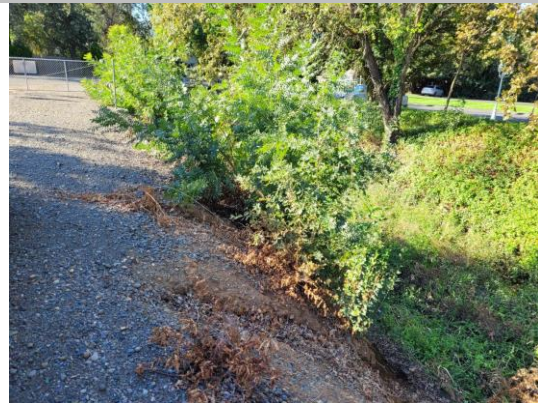
Photo 1 of 1 : FA\_2024\_NA0003\_68\_22\_20240924\_00006.jpg

LM Start	0.70	Rating **	M	Issue No.	22
LM End	0.70	Issue Type +	Ma	Location *	WS
Category	Earthen Levee			GPS Latitude/Longitude	
				Start	End
Item	Vegetation			39.773080°	39.773080°
				-121.845936°	-121.845936°
DWR ID	DWR_NA0003_04_f_2022_22

View of wild growth along the waterside slope and toe. Fall 2022.

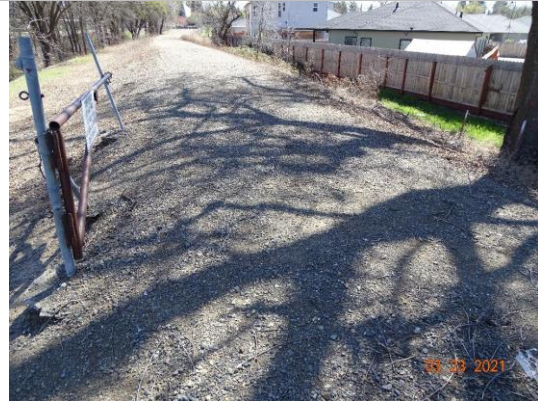
Photo 1 of 3 : UCIP\_FA\_2024\_67765\_100840.jpg

Comment Code					
Inspector Comment					
DS_ID:19287 FS_ID:67765 EP_NO: N/A Repair Type: Non-Urgent EVAL Issue: Crossing Status: Found UCIP Comments: 03/23/2021 Record remains Non-Urgent. Debris has been cleared. No permit has been identified authorizing pipe. DMP internal video inspection has not found pipe integrity issues. LOF of crossing is less or equal to 4. Recommend next video inspection in 5 years. (O.Yakimov - DWR UCIP) 03/07/2014 Needs cleaning and clearing the culvert. (P. Amatya - DWR UCIP) FIELD_STRUCT_DESC: 24-inch corrugated metal gravity drainage pipe through the levee, 9 feet below the crown. Flap gate on the waterside (WS) end. Concrete U-shaped headwall on each end. Grouted riprap apron on the landside (LS) end. Grouted riprap spillway on the WS end. [Additional Reference(s): DWR Levee Log, 1992 (HLM 0.96). USACE Sacramento O&M Manual, Unit 504, May 1965, Revised 2 February 2011, (HLM 0.96), listed as 24-inch pipe. USACE As-Built Drawing No. 50-04-3685, Sheets 11 and 41, STA 4+00, 19 May 1965]. FS Date: 3/23/2021 2:28:32 PM

Top of Levee: View of levee crown looking upstream

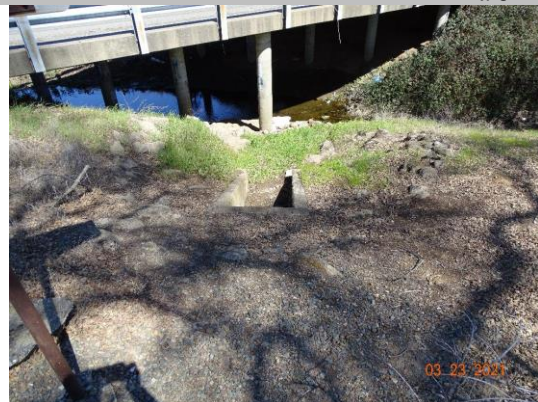
Photo 2 of 3 : UCIP\_FA\_2024\_67765\_100841.jpg

Water-Side: View of levee slope looking from crown

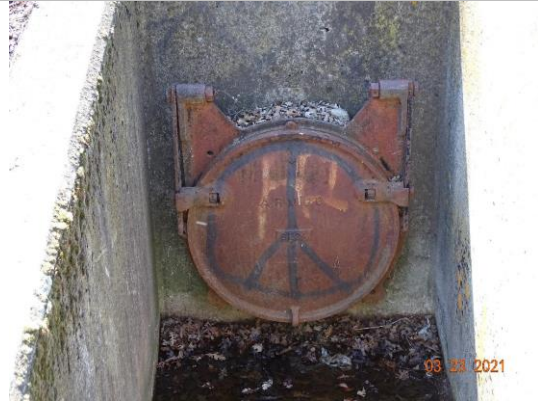
Photo 3 of 3 : UCIP\_FA\_2024\_67765\_100845.jpg

Water-Side: Headwall and flap gate at levee toe

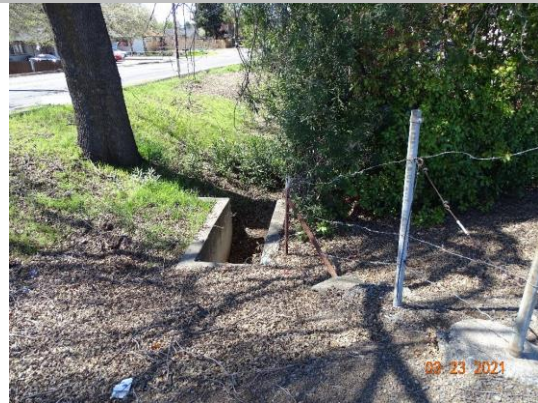
Photo 1 of 3 : UCIP\_FA\_2024\_67774\_100885.jpg

DS\_ID:19288  
FS\_ID:67774  
EP\_NO: N/A  
Repair Type: Non-Urgent  
EVAL Issue: 5, Pipe Damage  
Crossing Status: Found  
UCIP Comments: 03/23/2021 Record remains Non-Urgent. DMP internal video inspection has found pipe integrity issues. LOF of crossing is greater than or equal to 4.1 and less than 5. Crossing will be monitored until funding becomes available for rehabilitation. No permit has been identified authorizing pipe. (O.Yakimov - DWR UCIP)  
03/07/2014 Slide gate in CMP riser on waterside. No access to CMP riser. Needs cleaning and clearing the culvert. (P. Amatya - DWR UCIP)  
FIELD\_STRUCT\_DESC: 24-inch corrugated metal gravity drainage pipe through the levee and under the channel, 9.5 feet below the crown. Slide gate in a pipe riser on the waterside (WS) slope. Concrete U-shaped headwall on the landside (LS) end. [Additional Reference(s): DWR Levee Log, 1992 (HLM 0.98). USACE Sacramento O&M Manual, Unit 504, May 1965, Revised 2 February 2011, (HLM 0.98), listed as 24-inch pipe. USACE As-Built Drawing No. 50-04-3685, Sheet 11, between STA 2+20 and STA 3+20, 19 May 1965, shown as existing siphon through both levees and under channel].

Land-Side: View of levee slope looking from crown

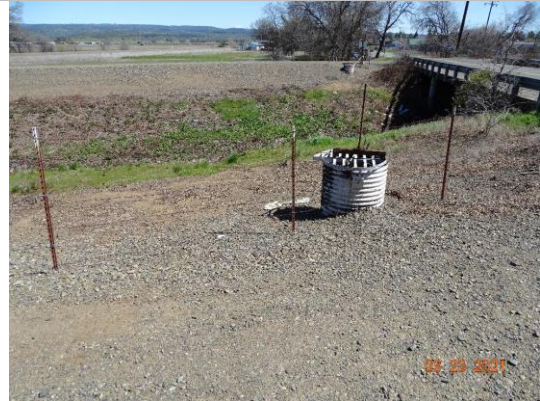
Photo 2 of 3 : UCIP\_FA\_2024\_67774\_100886.jpg

Water-Side: View of levee slope looking from crown. CMP riser with slide gate on levee slope

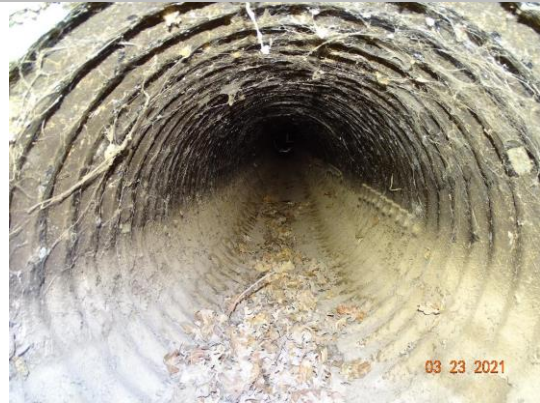
Photo 3 of 3 : UCIP\_FA\_2024\_67774\_100888.jpg

Land-Side: View inside of pipe looking from landside end

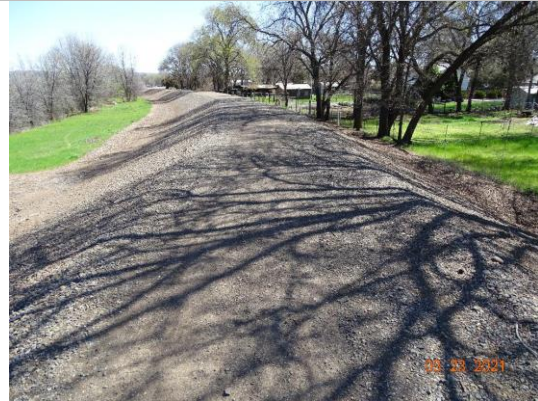
Photo 1 of 3 : UCIP\_FA\_2024\_67776\_100894.jpg

DS\_ID:19289  
FS\_ID:67776  
EP\_NO: N/A  
Repair Type: Non-Urgent  
EVAL Issue: 11, Maintenance Compliance Issue  
Crossing Status: Found  
UCIP Comments: 03/23/2021 Record remains Non-Urgent. Flap gate at waterside headwall is stuck closed. Hinges may need lubrication. No permit has been identified authorizing pipe. DMP internal video inspection has not found pipe integrity issues. LOF of crossing is less or equal to 4. Recommend next video inspection in 5 years. (O.Yakimov - DWR UCIP)  
03/07/2014 Needs cleaning and clearing the culvert. (P. Amatya - DWR UCIP)  
FIELD\_STRUCT\_DESC: 24-inch corrugated metal gravity drainage pipe through the levee, 11 feet below the crown. Flap gate on the waterside (WS) end. Concrete U-shaped headwall on each end. Grouted riprap apron on the landside (LS) end. Grouted riprap spillway on the WS end.  
[Additional Reference(s): DWR Levee Log, 1992 (HLM 1.15). USACE Sacramento O&M Manual, Unit 504, May 1965, Revised 2 February 2011, (HLM 1.15), listed as 24-inch pipe. USACE As-Built Drawing No. 50-04-3685, Sheet 41, STA 455+00, 19 May 1965].

Top of Levee: View of levee crown looking upstream

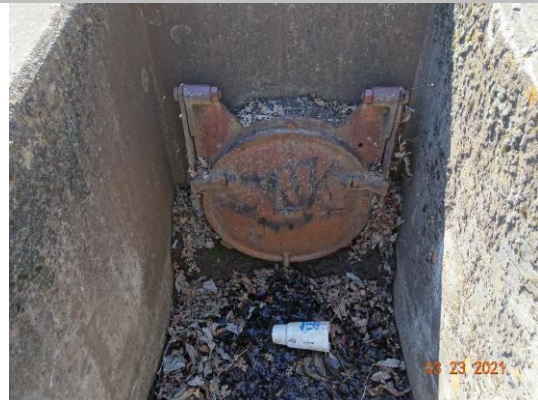
Photo 2 of 3 : UCIP\_FA\_2024\_67776\_100899.jpg

Water-Side: U-shaped headwall and flap gate at levee toe

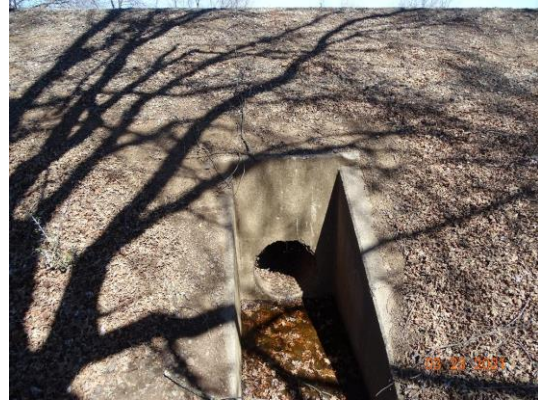
Photo 3 of 3 : UCIP\_FA\_2024\_67776\_100897.jpg

Land-Side: Levee slope, headwall, and pipe inlet

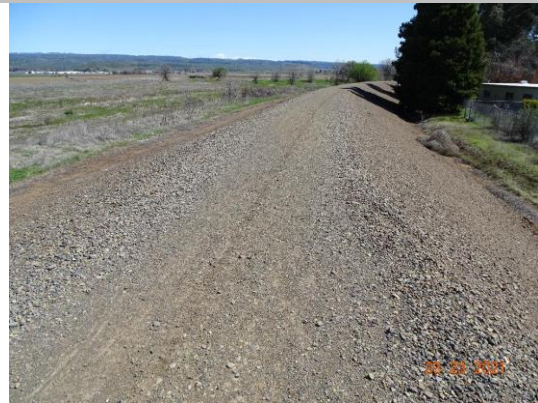
Photo 1 of 3 : UCIP\_FA\_2024\_67777\_100900.jpg

DS\_ID:19290  
FS\_ID:67777  
EP\_NO: N/A  
Repair Type: Non-Urgent  
EVAL Issue:  
Crossing Status: Found  
UCIP Comments: 03/23/2021 Record remains Non-Urgent. Debris has been cleared. No permit has been identified authorizing pipe. DMP internal video inspection has not found pipe integrity issues. LOF of crossing is less or equal to 4. Recommend next video inspection in 5 years. (O.Yakimov - DWR UCIP)  
03/07/2014 Needs cleaning and clearing the culvert. (P. Amatya - DWR UCIP)  
FIELD\_STRUCT\_DESC: 24-inch corrugated metal gravity drainage pipe through the levee, 13 feet below the crown. Flap gate on the waterside (WS) end. Concrete U-shaped headwall on each end. Grouted riprap apron on the landside (LS) end. Grouted riprap spillway on the WS end. [Additional Reference(s): DWR Levee Log, 1992 (HLM 1.39). USACE Sacramento O&M Manual, Unit 504, May 1965, Revised 2 February 2011, (HLM 1.41), listed as 24-inch pipe. USACE As-Built Drawing No. 50-04-3685, Sheets 9 and 40, STA 442+05, 19 May 1965].

Top of Levee: View of levee crown looking upstream
