**Flood Control Project Maintenance  
Levee Inspections**

**Maintenance Issue Types Only, Levee Inspection Report By Mile - Fall 2024**

**Butte County Department of Public Works**

Waterway	Bank	Unit Miles	Inspection Start/End	Inspector
Unit No. 01 Mud Creek	Right	6.80	09/19/2024 09/19/2024	Makar Sokol

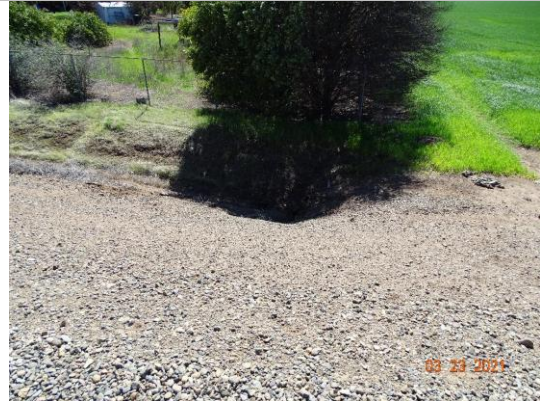
Photo 2 of 3 : UCIP\_FA\_2024\_67777\_100901.jpg

Land-Side: View of levee slope looking from crown

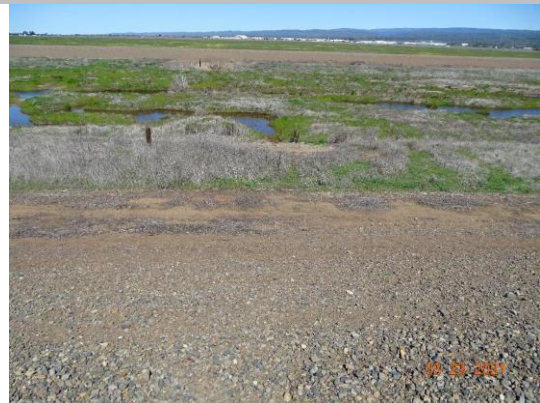
Photo 3 of 3 : UCIP\_FA\_2024\_67777\_100902.jpg

Water-Side: View of levee slope looking from crown

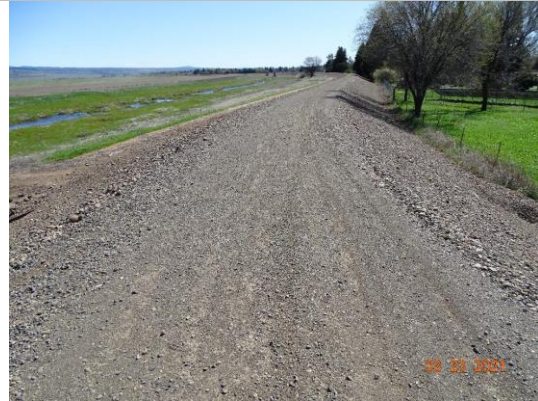
Photo 1 of 3 : UCIP\_FA\_2024\_67779\_100908.jpg

DS\_ID:19291  
FS\_ID:67779  
EP\_NO: N/A  
Repair Type: No Action Needed  
EVAL Issue:  
Crossing Status: Found  
UCIP Comments: 09/15/2023 Record updated from Non-Urgent to No Action Needed. Pipe was CIPP lined. DMP internal video inspection has found none or minor pipe defects. Recommend next video inspection in 5 years. (O. Yakimov - DWR UCIP)  
03/23/2021 Record remains Non-Urgent. Debris has been cleared. DMP internal video inspection has found pipe integrity issues. LOF of crossing is greater than or equal to 4.1 and less than 5. Crossing will be monitored until funding becomes available for rehabilitation. No permit has been identified authorizing pipe. (O.Yakimov - DWR UCIP)  
03/07/2014 Needs cleaning and clearing the culvert. (P. Amatya - DWR UCIP)  
FIELD\_STRUCT\_DESC: 24-inch CIPP-lined corrugated metal gravity drainage pipe through the levee, 11 feet below the crown. Flap gate on the waterside (WS) end. Concrete U-shaped headwall on each end. Grouted riprap apron on the landside (LS) end. Grouted riprap spillway on the WS end. [Additional Reference(s): DWR Levee Log, 1992 (HLM 2.22). USACE Sacramento O&M Manual, Unit 504, May 1965, Revised 2 February 2011, (HLM 2.22), listed as 24-inch pipe. USACE As-Built Drawing No. 50-04-3685, Sheets 9 and 41, STA 400+00, 19 May 1965].

Top of Levee: View of levee crown looking upstream

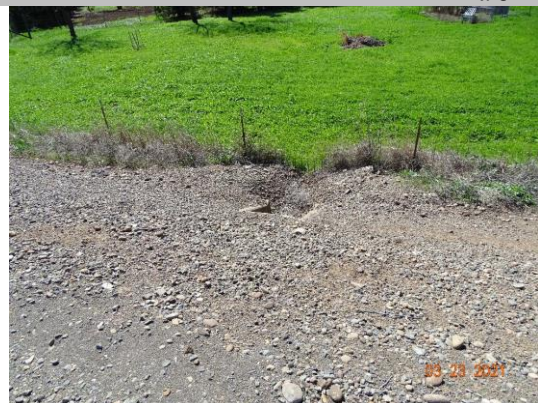
Photo 2 of 3 : UCIP\_FA\_2024\_67779\_100909.jpg

Land-Side: View of levee slope looking from crown

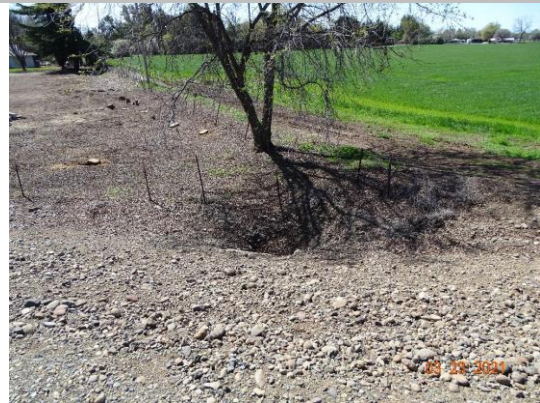
Photo 1 of 3 : UCIP\_FA\_2024\_67780\_100915.jpg

DS\_ID:19292  
FS\_ID:67780  
EP\_NO: N/A  
Repair Type: No Action Needed  
EVAL Issue:  
Crossing Status: Found  
UCIP Comments: 09/15/2023 Record updated from Non-Urgent to No Action Needed. Pipe was CIPP lined. DMP internal video inspection has found none or minor pipe defects. Recommend next video inspection in 5 years. (O. Yakimov - DWR UCIP)  
03/23/2021 Record remains Non-Urgent. Debris has been cleared. DMP internal video inspection has found pipe integrity issues. LOF of crossing is greater than or equal to 4.1 and less than 5. Crossing will be monitored until funding becomes available for rehabilitation. No permit has been identified authorizing pipe. (O.Yakimov - DWR UCIP)  
03/07/2014 Needs cleaning and clearing the culvert. (P. Amatya - DWR UCIP)  
FIELD\_STRUCT\_DESC: 24-inch CIPP-lined corrugated metal gravity drainage pipe through the levee, 11 feet below the crown. Flap gate on the waterside (WS) end. Concrete U-shaped headwall on each end. Grouted riprap apron on the landside (LS) end. Grouted riprap spillway on the WS end. [Additional Reference(s): DWR Levee Log, 1992 (HLM 2.56). USACE Sacramento O&M Manual, Unit 504, May 1965, Revised 2 February 2011, (HLM 2.56), listed as 24-inch pipe. USACE As-Built Drawing No. 50-04-3685, Sheets 7 and 41, STA 382+90, 19 May 1965].

Land-Side: View of levee slope looking from crown

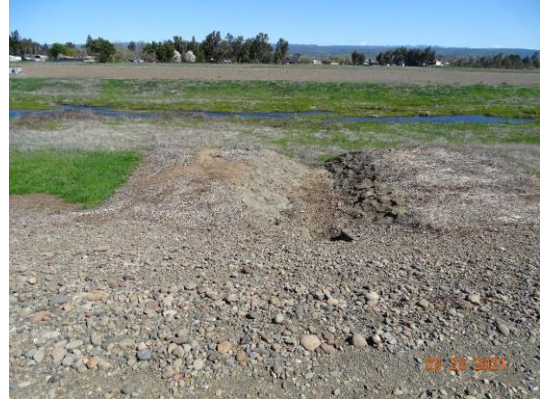
Photo 2 of 3 : UCIP\_FA\_2024\_67780\_100916.jpg

Water-Side: View of levee slope looking from crown

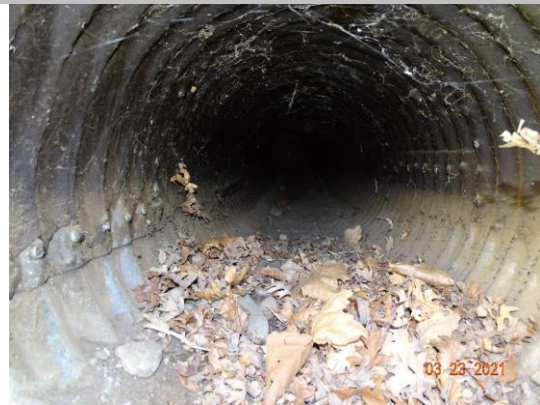
Photo 3 of 3 : UCIP\_FA\_2024\_67780\_100919.jpg

Water-Side: View inside of pipe looking from landside end
