**Flood Control Project Maintenance
Levee Inspections**

Fall 2012 Levee Maintenance Deficiency Summary Report

San Joaquin River Basin

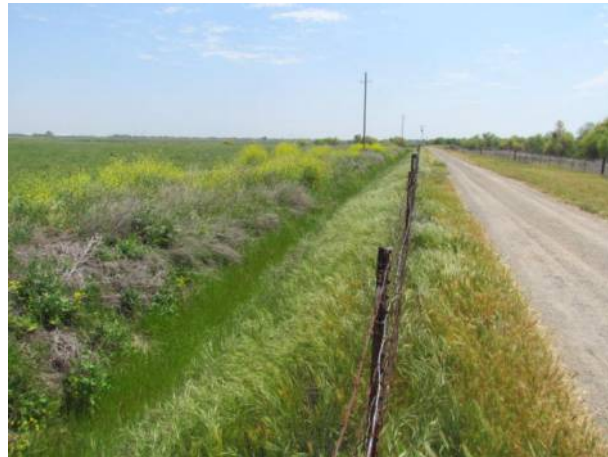
richard_f_20121101_053.jpg

Looking south at irrigation ditch at landside toe.

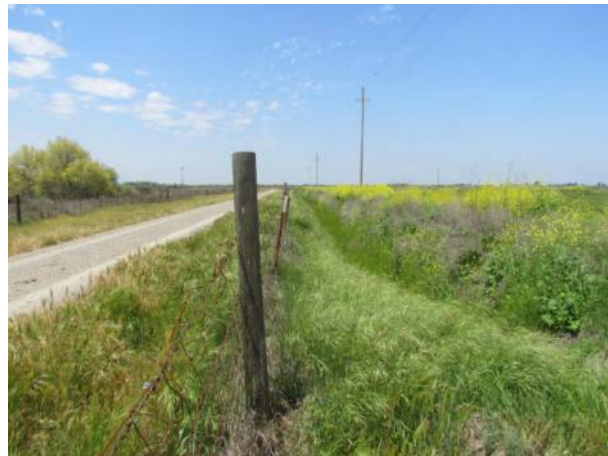
richard_f_20121101_054.jpg

Levee Mile Report Line	14
Start Levee Mile	4.00
End Levee Mile	4.08
Location	Land Side
Category	Earthen Levee
Item	Encroachments

Looking north at irrigation ditch at landside toe.

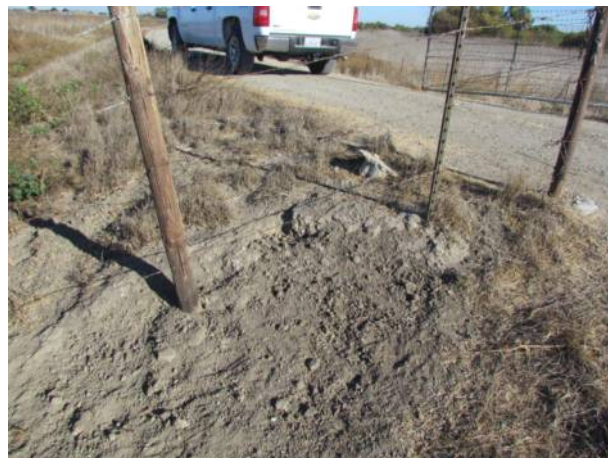
richard_f_20121113_863.JPG

Looking south at repaired rodent site on landside slope. (Fall 2012)

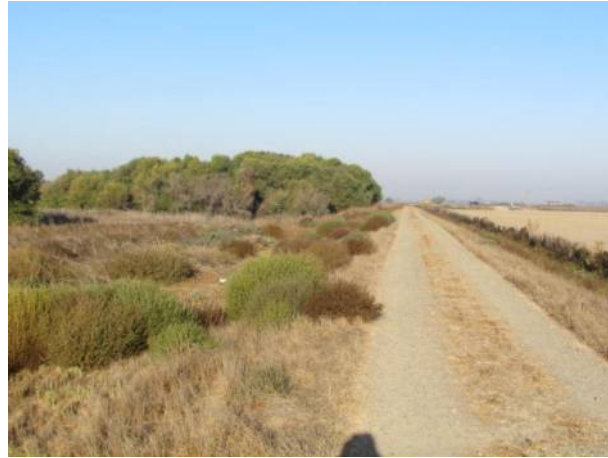
richard_f_20121113_864.JPG

Looking south at typical view of tumble weeds on landside and waterside slope.

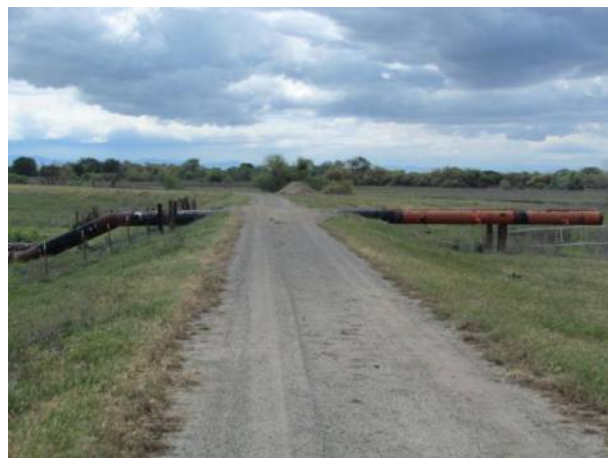
richard_f_20121101_055.jpg

Levee Mile Report Line	27
Start Levee Mile	19.33
End Levee Mile	19.33
Location	Crown
Category	Earthen Levee
Item	Encroachments

Looking south at pipe across levee crown.

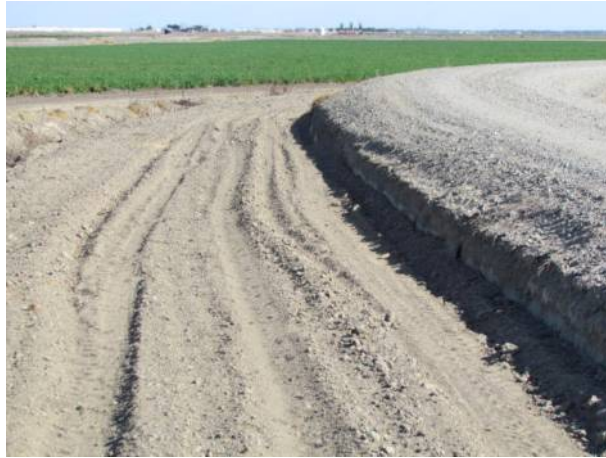
richard_f_20121113_865.JPG

Looking west at farmer discing landside slope.

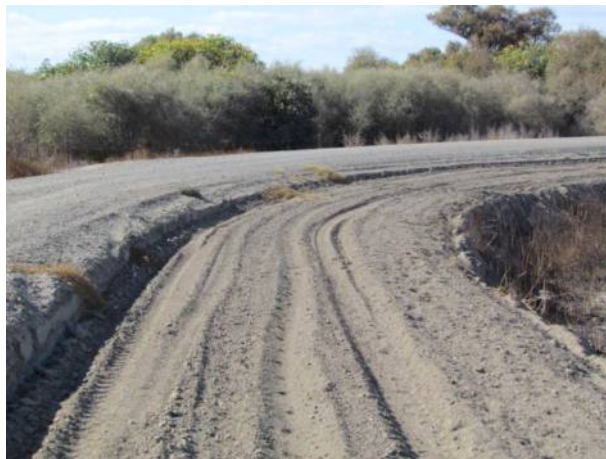
richard_f_20121113_866.JPG

Levee Mile Report Line	28
Start Levee Mile	21.46
End Levee Mile	22.02
Location	Land Side
Category	Earthen Levee
Item	Encroachments

Looking east at farmer discing into landside slope.

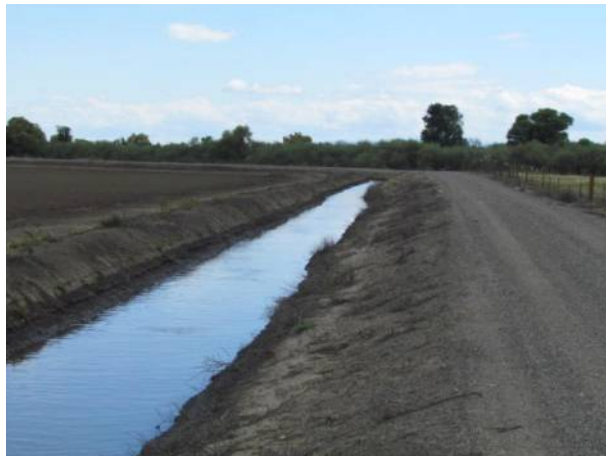
richard_f_20121101_056.jpg

Levee Mile Report Line	29
Start Levee Mile	22.09
End Levee Mile	22.56
Location	Land Side
Category	Earthen Levee
Item	Encroachments

Looking upstream at irrigation at landside toe.

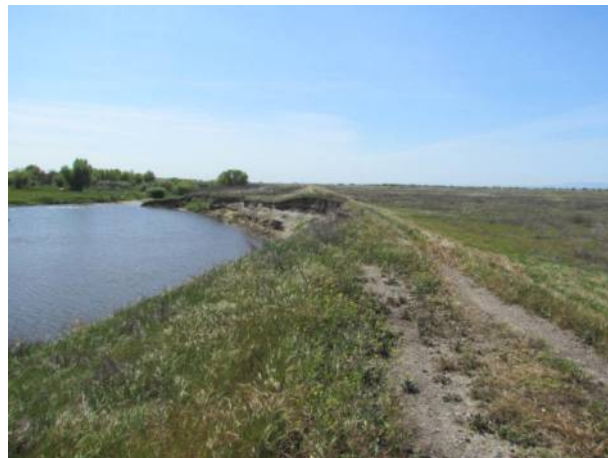
richard_f_20121101_067.jpg

Levee Mile Report Line	3
Start Levee Mile	0.77
End Levee Mile	0.77
Location	Water Side
Category	Earthen Levee
Item	Erosion / Bank Caving

Looking south at large erosion on waterside slope. (Spring 2012)

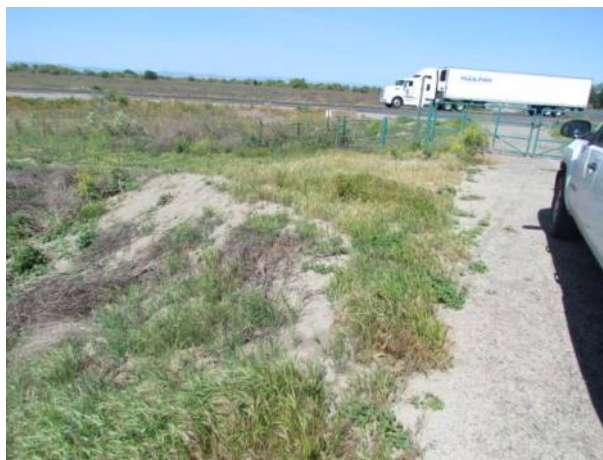
richard_f_20121101_064.jpg

Looking northwest at ramp on landside slope near Hwy 140.

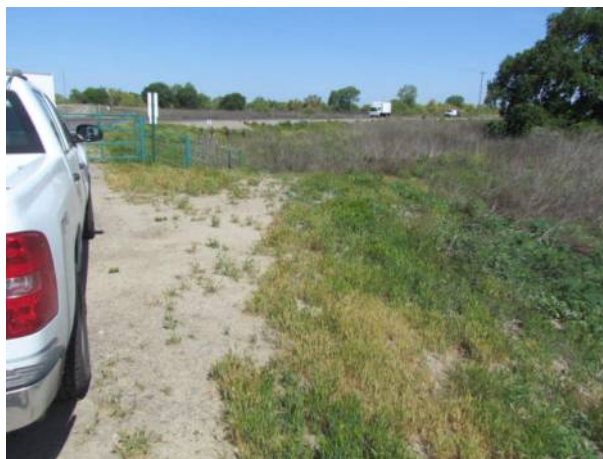
richard_f_20121101_065.jpg

Levee Mile Report Line	5
Start Levee Mile	2.33
End Levee Mile	2.33
Location	Land Side
Category	Earthen Levee
Item	Encroachments

Looking northeast at ramp on waterside slope near Hwy 140.

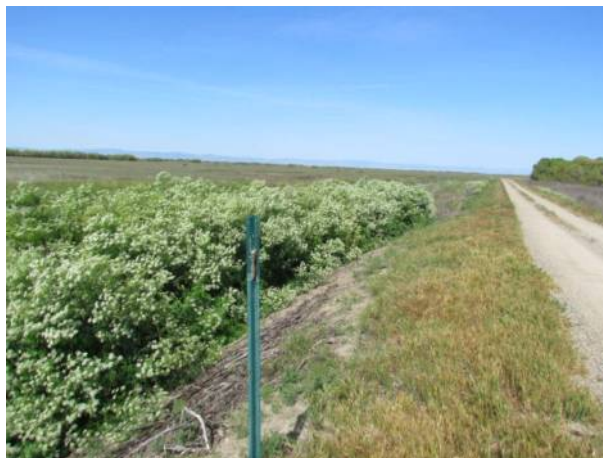
richard_f_20121101_068.jpg

Levee Mile Report Line	6
Start Levee Mile	7.76
End Levee Mile	7.76
Location	Land Side
Category	Earthen Levee
Item	Vegetation

Looking north dense vegetation at landside slope and toe.

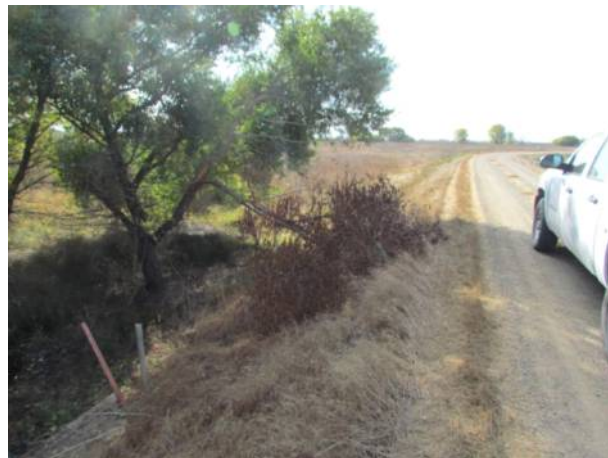
richard_f_20121115_907.JPG

Looking north at broken tree limb on landside slope.

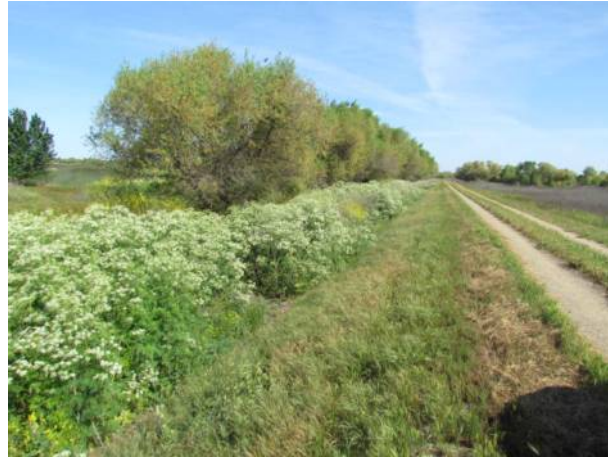
richard_f_20121101_070.jpg

Looking northwest at dense vegetation on landside slope and toe.

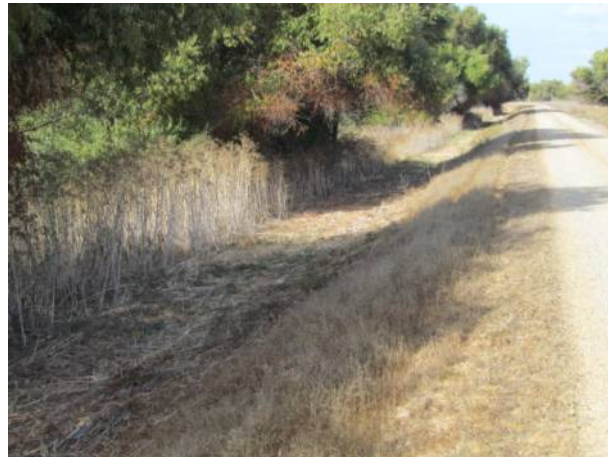
richard_f_20121115_906.JPG

Levee Mile Report Line	3
Start Levee Mile	9.50
End Levee Mile	9.98
Location	Land Side
Category	Earthen Levee
Item	Vegetation

Looking north at removed wild growth on landside toe. (Fall 2012)

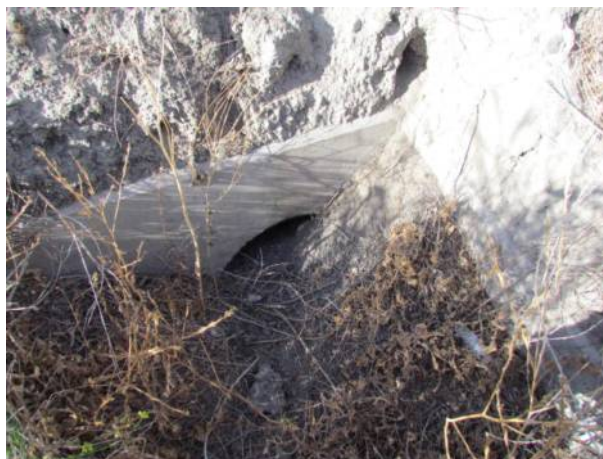
richard_f_20121115_900.JPG

Levee Mile Report Line	2
Start Levee Mile	0.43
End Levee Mile	0.43
Location	Land Side
Category	Interior Drainage & Piping Systems
Item	Vegetation & Obstructions

Looking east at inlet of pipe on landside toe.

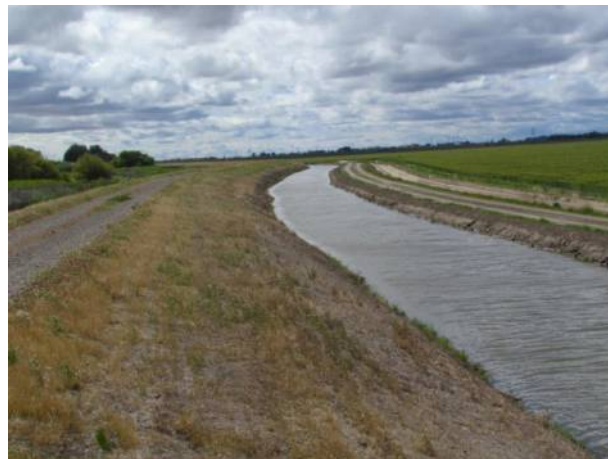
richard_f_20121101_071.jpg

Levee Mile Report Line	2
Start Levee Mile	0.32
End Levee Mile	1.49
Location	Crown
Category	Earthen Levee
Item	Encroachments

Looking north at irrigation ditch at landside toe.

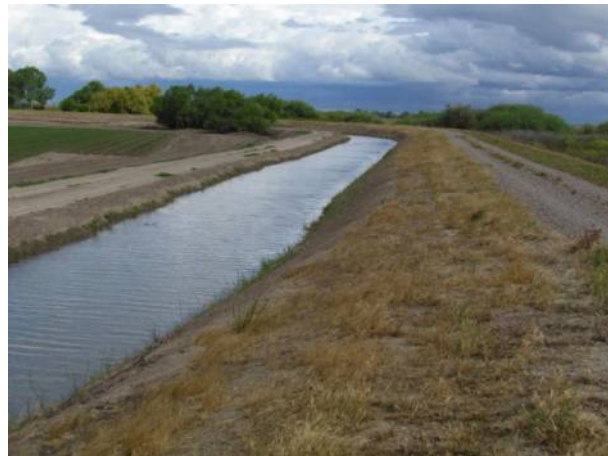
richard_f_20121101_072.jpg

Levee Mile Report Line	2
Start Levee Mile	0.32
End Levee Mile	1.49
Location	Crown
Category	Earthen Levee
Item	Encroachments

Looking north at irrigation ditch at landside toe.

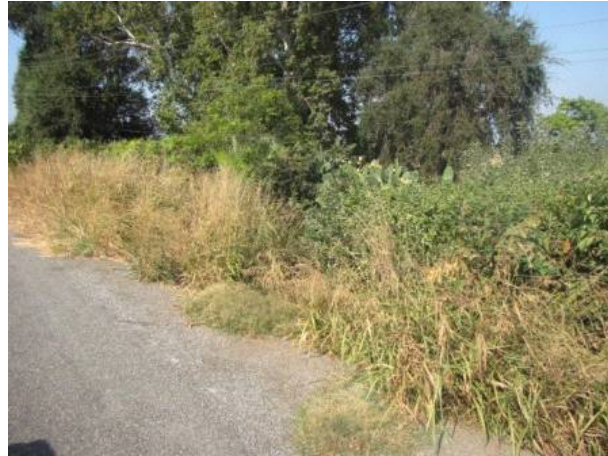
richard_f_20121101_074.jpg

Looking south at dense trees on landside slope.

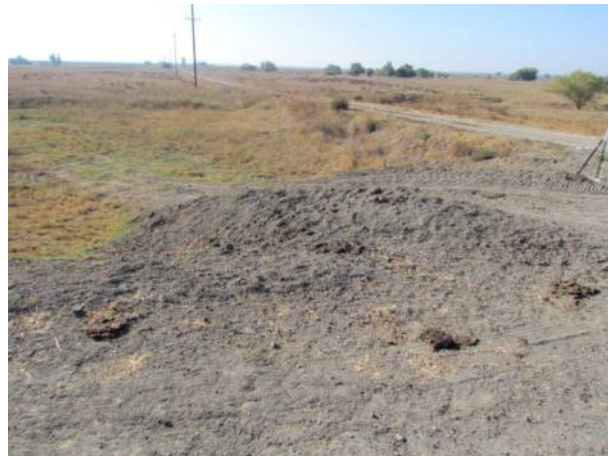
richard_f_20121113_868.JPG

Levee Mile Report Line	3
Start Levee Mile	3.19
End Levee Mile	3.19
Location	Water Side
Category	Earthen Levee
Item	Encroachments

Looking northwest at unauthorized ramp on waterside slope.

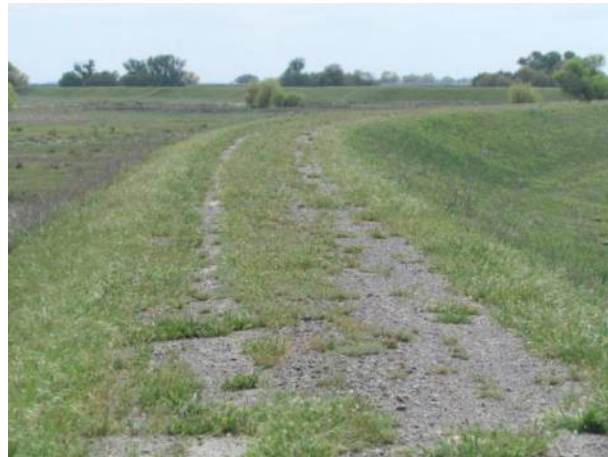
richard_f_20121101_076.jpg

Levee Mile Report Line	6
Start Levee Mile	4.50
End Levee Mile	5.61
Location	Crown
Category	Earthen Levee
Item	Crown Surface / Depressions / Rutting

Looking south at vegetation on levee crown.

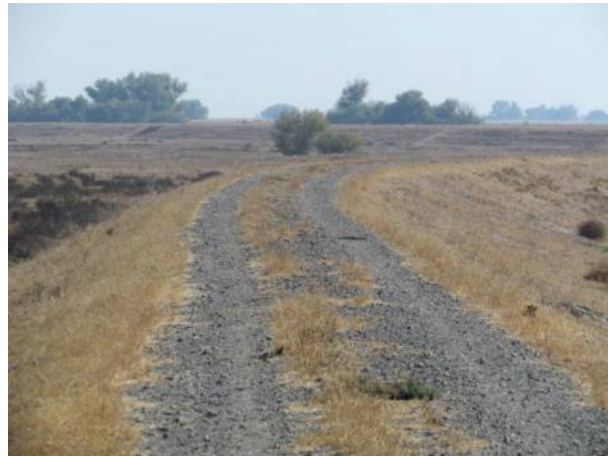
richard_f_20121115_876.JPG

Levee Mile Report Line	6
Start Levee Mile	4.50
End Levee Mile	5.61
Location	Crown
Category	Earthen Levee
Item	Crown Surface / Depressions / Rutting

Looking south at un-regraded levee crown.

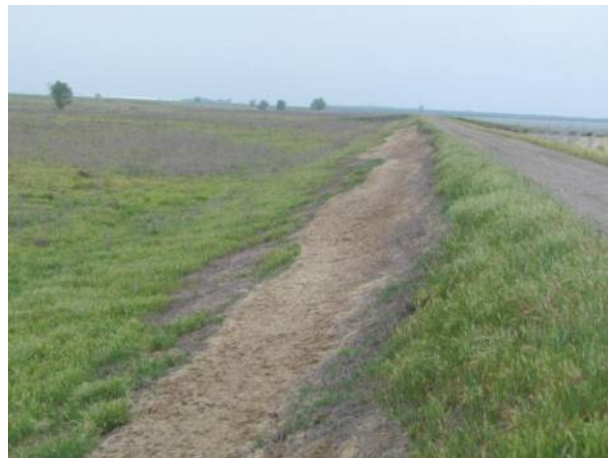
richard_f_20121101_077.jpg

Levee Mile Report Line	21
Start Levee Mile	29.58
End Levee Mile	29.70
Location	Water Side
Category	Earthen Levee
Item	Erosion / Bank Caving

Looking south at erosion caused by livestock on landside slope.

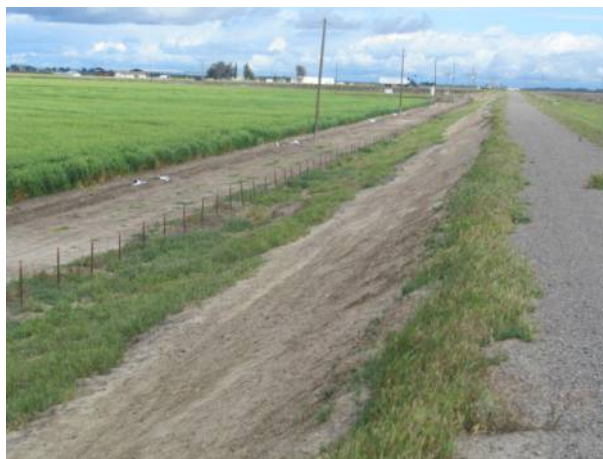
richard_f_20121101_082.jpg

Levee Mile Report Line	13
Start Levee Mile	24.50
End Levee Mile	24.93
Location	Land Side
Category	Earthen Levee
Item	Slope Stability

Looking north at livestock erosion on landside slope.

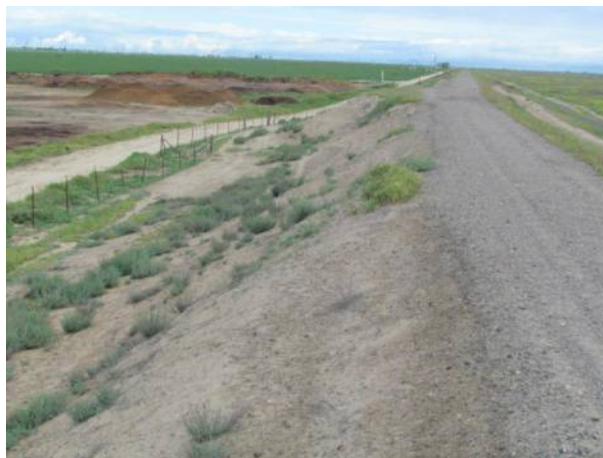
richard_f_20121101_080.jpg

Levee Mile Report Line	14
Start Levee Mile	27.56
End Levee Mile	27.87
Location	Land Side
Category	Earthen Levee
Item	Slope Stability

Looking north at livestock erosion on landside shoulder and slope.

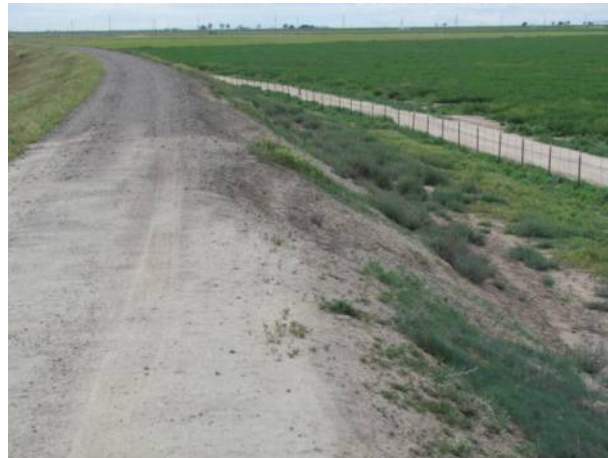
richard_f_20121101_081.jpg

Looking south at livestock erosion on landside shoulder and slope.

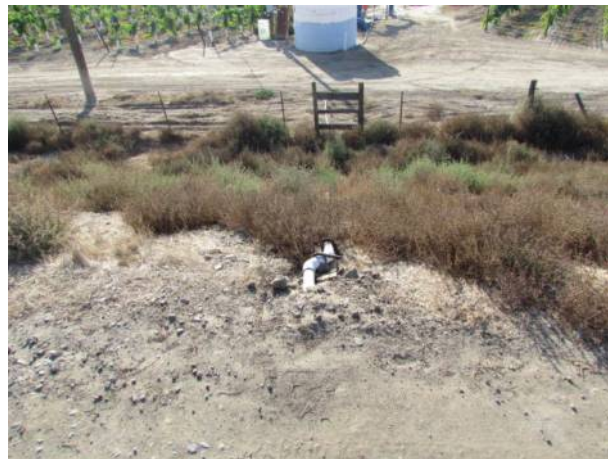
richard_f_20121115_896.JPG

Looking east at 3/4 inch PVC pipe on landside slope.

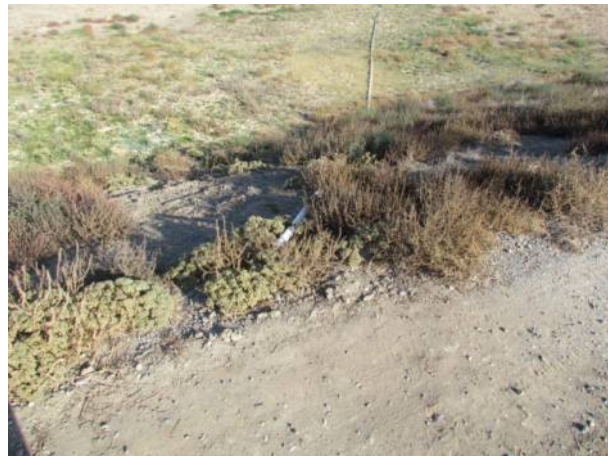
richard_f_20121115_897.JPG

Levee Mile Report Line	16
Start Levee Mile	30.41
End Levee Mile	30.41
Location	Crown
Category	Earthen Levee
Item	Encroachments

Looking west at 3/4 inch PVC pipe on waterside slope.

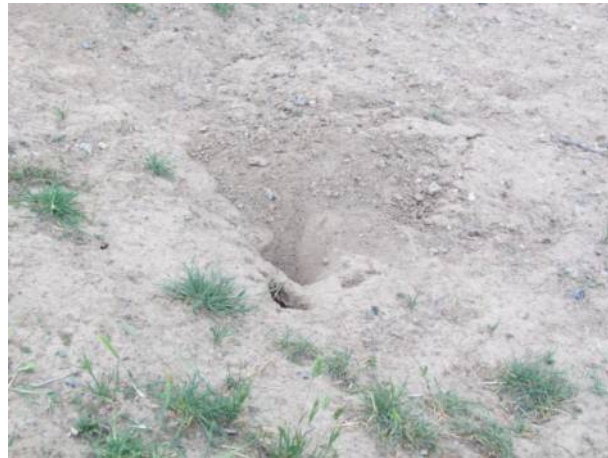
richard_f_20121101_078.jpg

Looking at typical rodent hole on landside slope.

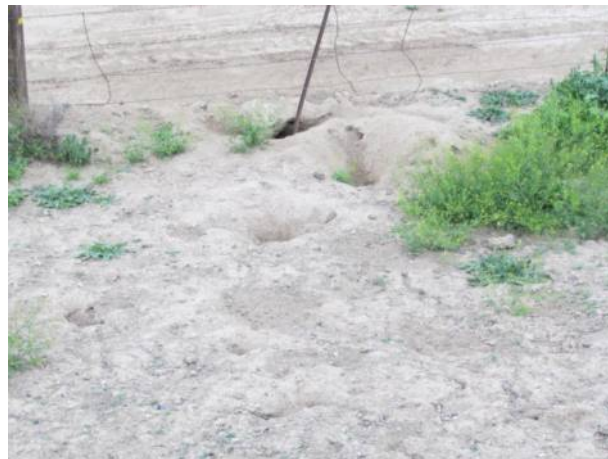
richard_f_20121101_079.jpg

Levee Mile Report Line	17
Start Levee Mile	31.01
End Levee Mile	31.01
Location	Land Side
Category	Earthen Levee
Item	Animal Control

Looking west at rodent holes on landside slope and toe near fence line.

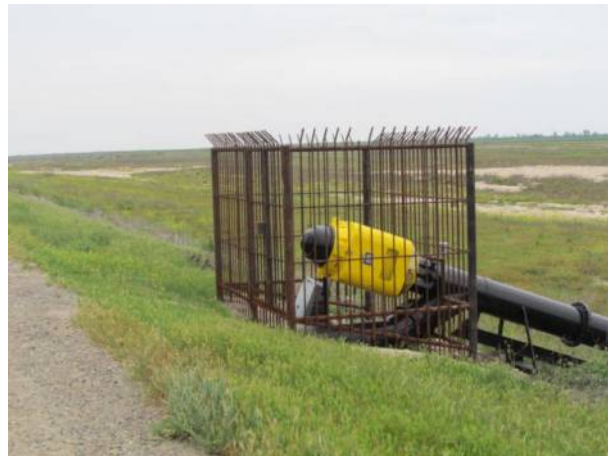
richard_f_20121101_083.jpg

Levee Mile Report Line	18
Start Levee Mile	32.99
End Levee Mile	32.99
Location	Water Side
Category	Earthen Levee
Item	Encroachments

Looking northeast at new metal fence around slant pump on waterside slope.

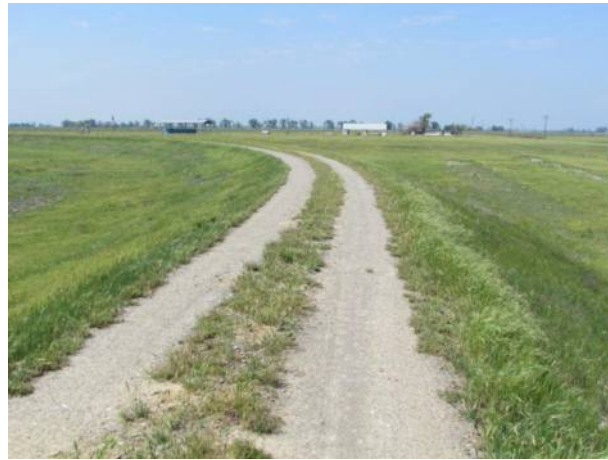
richard_f_20121101_085.jpg

Looking east at vegetation on levee crown.

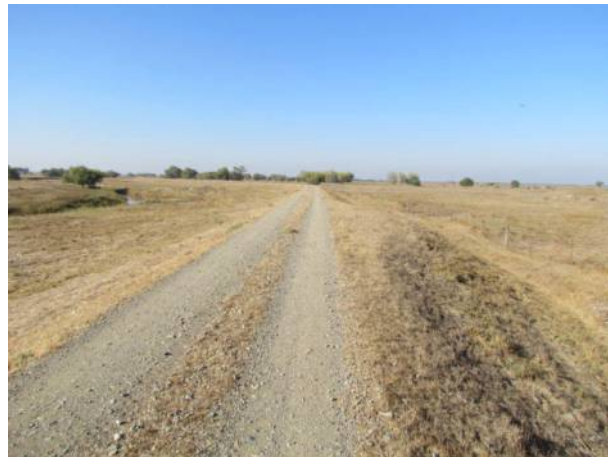
richard_f_20121115_869.JPG

Levee Mile Report Line	1
Start Levee Mile	0.11
End Levee Mile	2.57
Location	Crown
Category	Earthen Levee
Item	Crown Surface / Depressions / Rutting

Looking east at un-regraded levee crown. (Fall 2012)

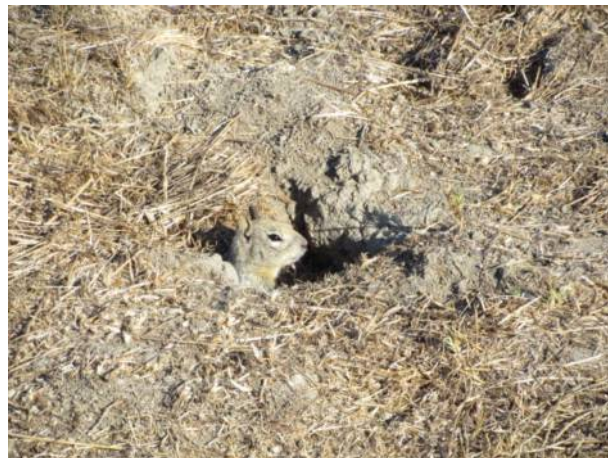
richard_f_20121115_870.JPG

Levee Mile Report Line	3
Start Levee Mile	1.22
End Levee Mile	1.22
Location	Land Side
Category	Earthen Levee
Item	Animal Control

Looking at east at active rodent holes on landside berm.

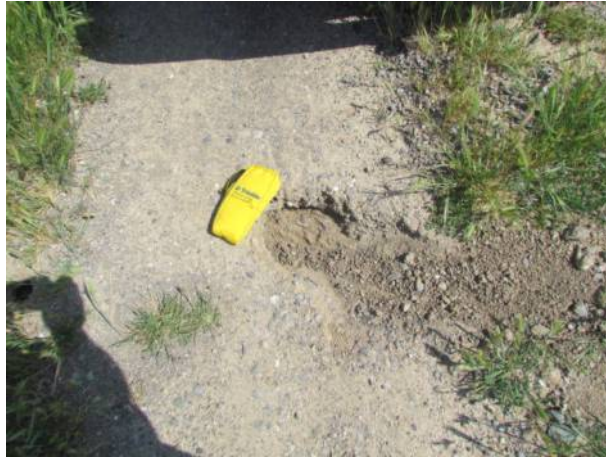
richard_f_20121101_087.jpg

Looking at rodent hole on levee crown.

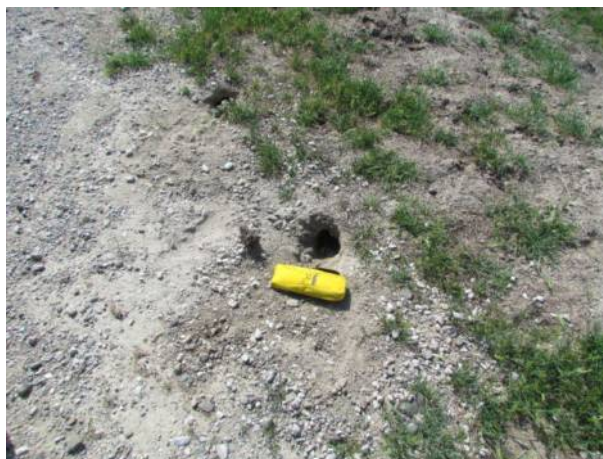
richard_f_20121101_088.jpg

Levee Mile Report Line	5
Start Levee Mile	2.07
End Levee Mile	2.12
Location	Land Side
Category	Earthen Levee
Item	Animal Control

Looking at typical rodent hole along the section.

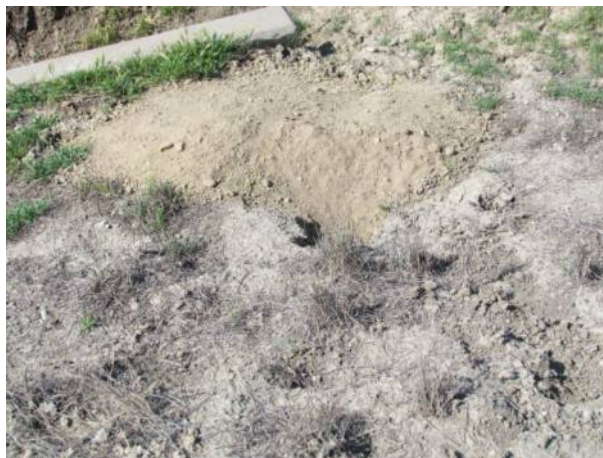
richard_f_20121101_089.jpg

Levee Mile Report Line	5
Start Levee Mile	2.07
End Levee Mile	2.12
Location	Land Side
Category	Earthen Levee
Item	Animal Control

Looking at typical rodent hole on landside slope near headwall.

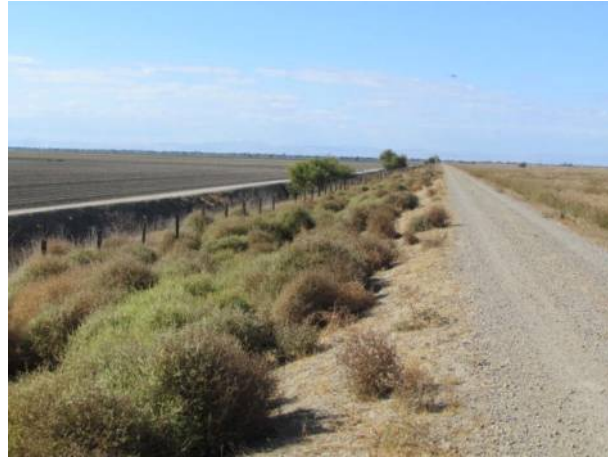
richard_f_20121115_904.JPG

Looking at dense tumble weeds on landside and waterside slopes.

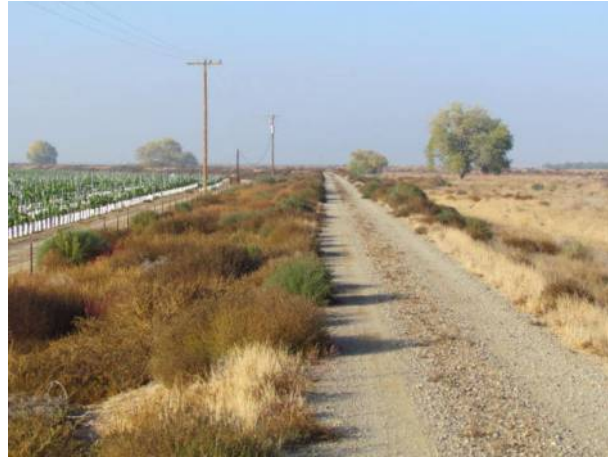
richard_f_20121115_883.JPG

Looking west at typical view of tumble weeds on levee slopes.

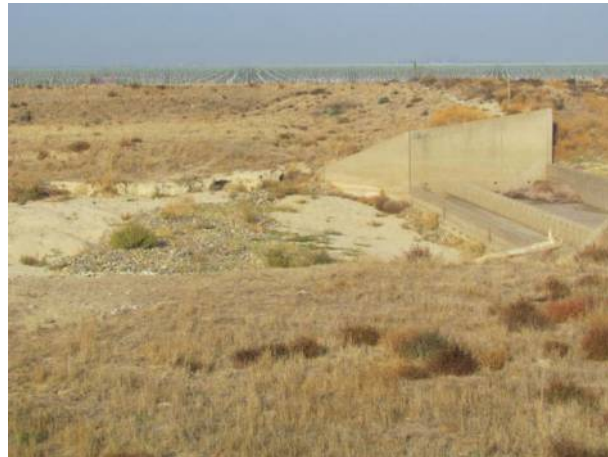
richard_f_20121115_884.JPG

Levee Mile Report Line	4
Start Levee Mile	0.08
End Levee Mile	0.08
Location	Water Side
Category	Channels
Item	Concrete Foundations

Looking south at erosion in channel near drop structure.

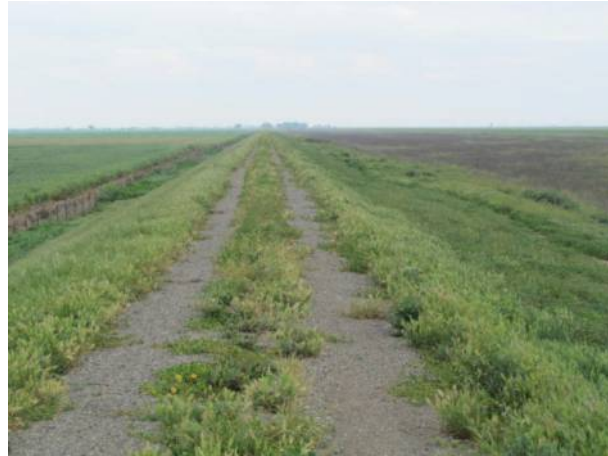
Levee Mile Report Line	2
Start Levee Mile	0.00
End Levee Mile	1.99
Location	Crown
Category	Earthen Levee
Item	Crown Surface / Depressions / Rutting
Looking east at typical view of vegetation on levee crown.	
richard_f_20121101_093.jpg

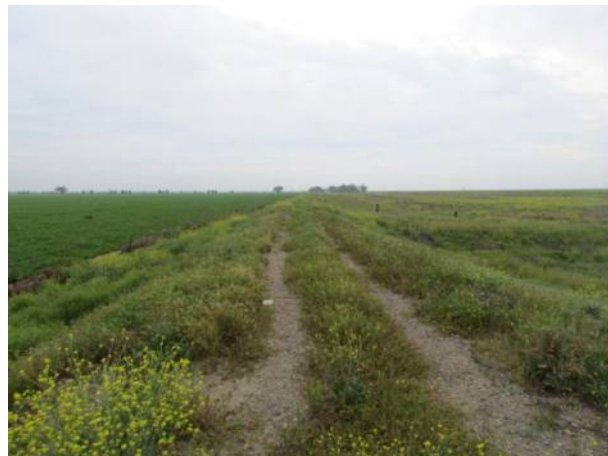
Levee Mile Report Line	3
Start Levee Mile	0.00
End Levee Mile	1.99
Location	Water Side
Category	Earthen Levee
Item	Vegetation
Looking east at unwanted vegetation on levee crown and slope.	
richard_f_20121101_092.jpg

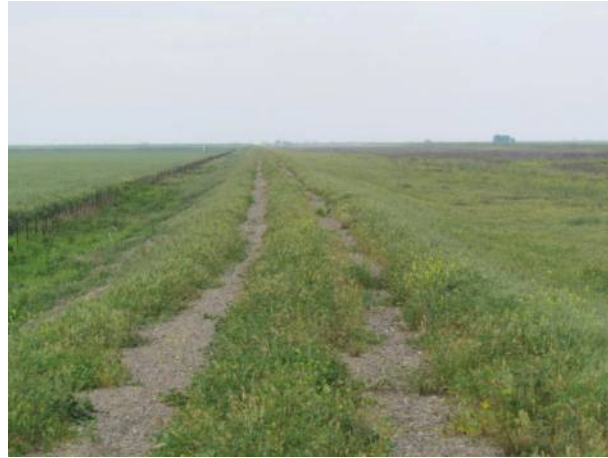
richard_f_20121101_095.jpg

Looking west (downstream) at unwanted vegetation on levee crown.

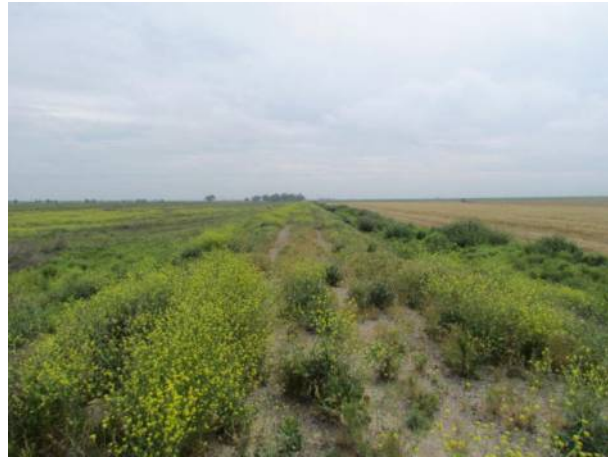
richard_f_20121101_094.jpg

Levee Mile Report Line	3
Start Levee Mile	0.00
End Levee Mile	1.97
Location	Land Side
Category	Earthen Levee
Item	Vegetation

Looking east (upstream) at unwanted vegetation on both levee slope and levee crown.

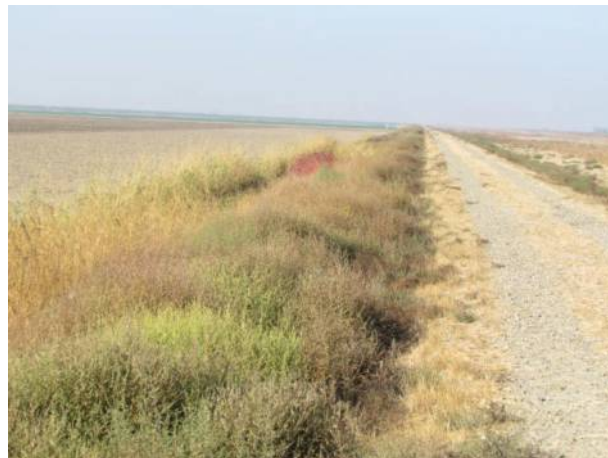
richard_f_20121115_886.JPG

Levee Mile Report Line	3
Start Levee Mile	0.00
End Levee Mile	1.97
Location	Land Side
Category	Earthen Levee
Item	Vegetation

Looking west at typical view dense vegetation on waterside and landside slopes.

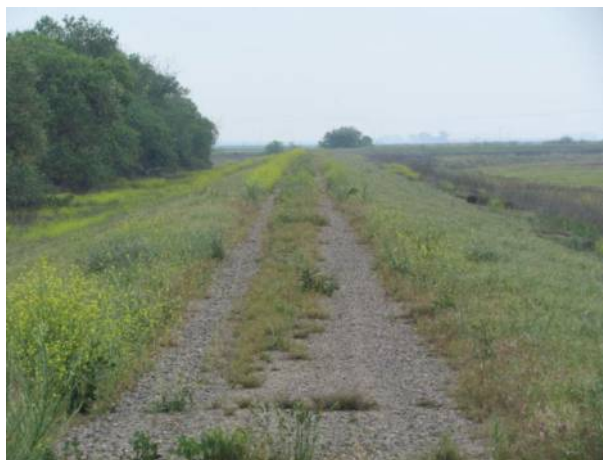
richard_f_20121101_097.jpg

Looking south at unwanted vegetation on levee crown.

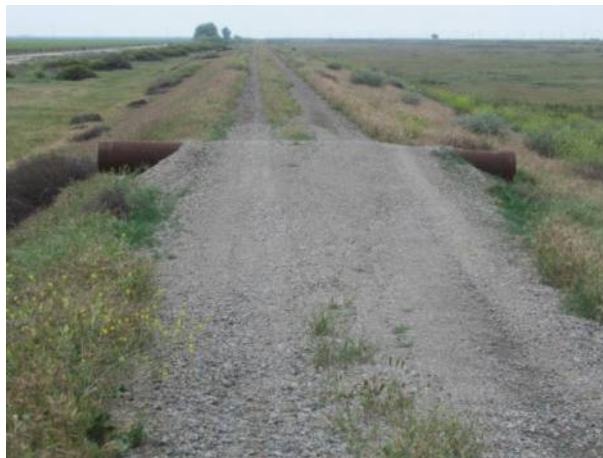
richard_f_20121101_096.jpg

Levee Mile Report Line	4
Start Levee Mile	4.69
End Levee Mile	4.69
Location	Crown
Category	Earthen Levee
Item	Encroachments

Looking south at unauthorized steel pipe across levee crown.

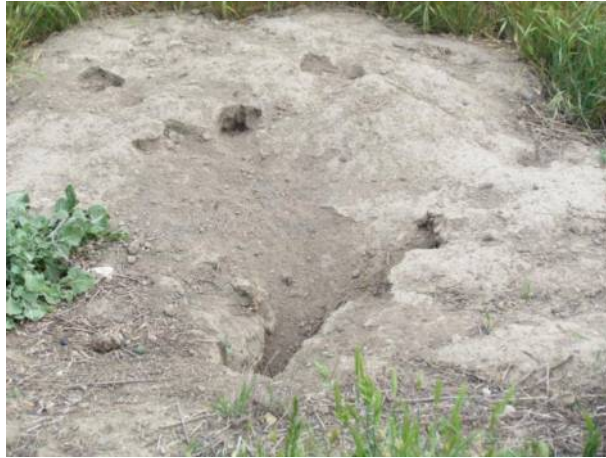
richard_f_20121101_098.jpg

Looking at several rodent holes on landside slope.

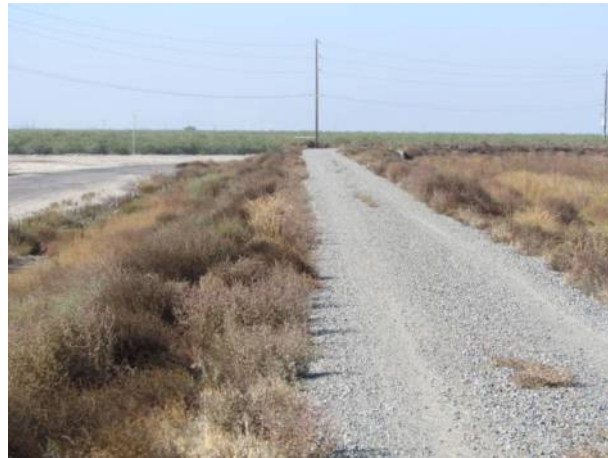
richard_f_20121115_894.JPG

Looking north at dense tumble weeds on levee slopes.

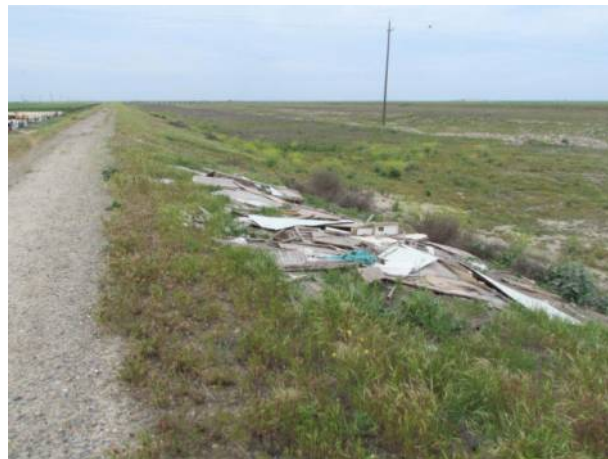
richard_f_20121101_099.jpg

Levee Mile Report Line	3
Start Levee Mile	8.04
End Levee Mile	8.04
Location	Water Side
Category	Earthen Levee
Item	Encroachments

Looking north at garbage on waterside slope.

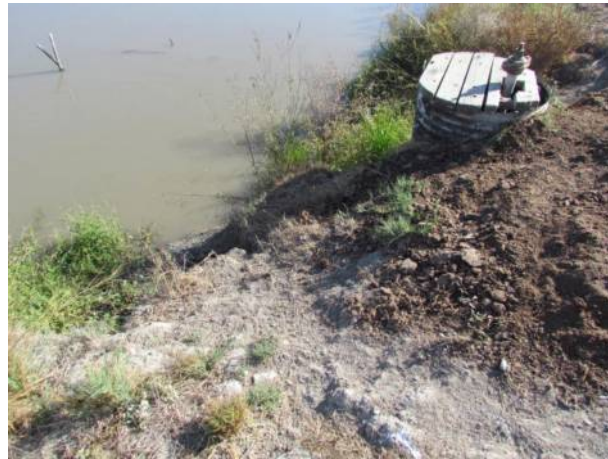
richard_f_20121115_873.JPG

Levee Mile Report Line	1
Start Levee Mile	0.10
End Levee Mile	0.10
Location	Water Side
Category	Earthen Levee
Item	Erosion / Bank Caving

Looking south at erosion near screw gate. (Fall 2012)

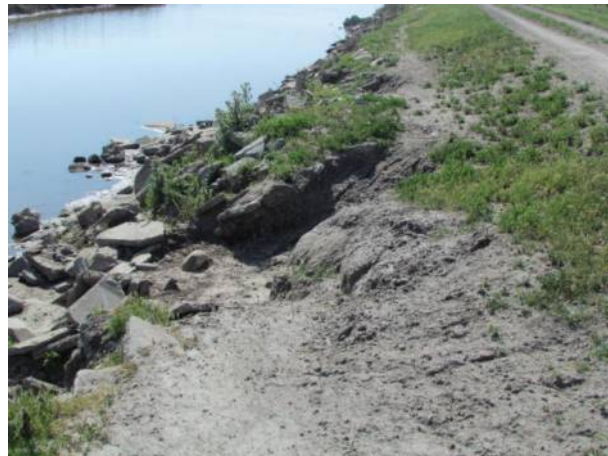
richard_f_20121101_100.jpg

Levee Mile Report Line	3
Start Levee Mile	2.65
End Levee Mile	3.65
Location	Water Side
Category	Earthen Levee
Item	Animal Control

Looking northeast at animal erosion on waterside slope.

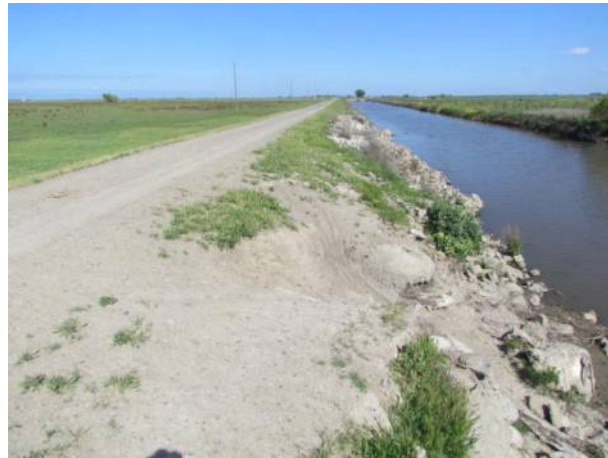
richard_f_20121101_101.jpg

Looking south at animal erosion on waterside slope.

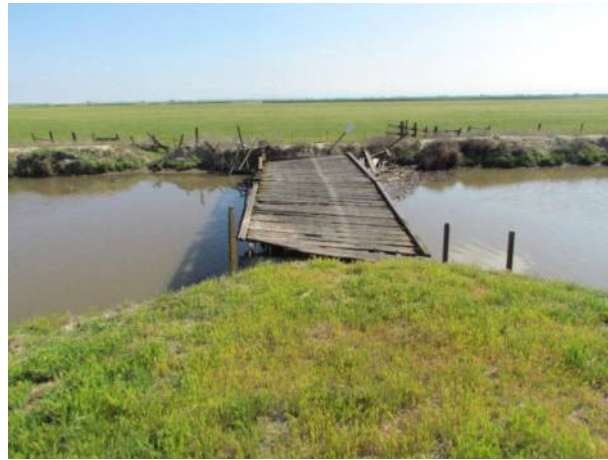
richard_f_20121101_102.jpg

Looking east at dilapidated bridge across canal.

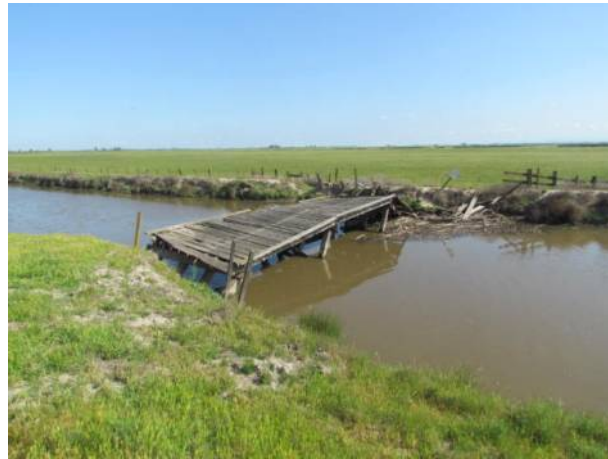
richard_f_20121101_103.jpg

Looking northeas at dilapidated bridge across canal.

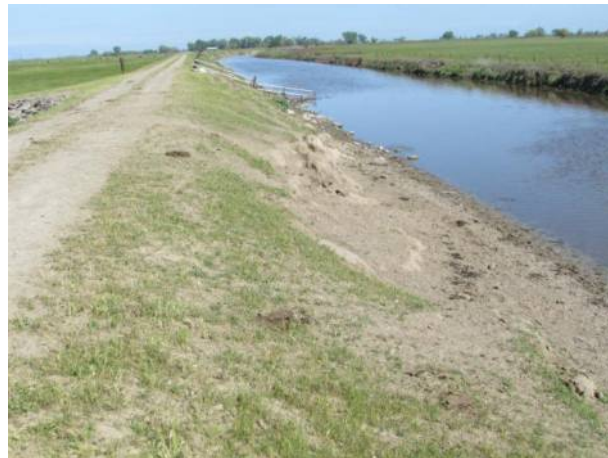
richard_f_20121101_105.jpg

DWR ID: DWR_NA0010_22A_s_2012_3										
8	4.80	4.86	Earthen Levee	Animal Control	WS	M Ma	A2 : Repair the levee slope damaged by livestock and prevent large animal access. Inspector Comments: Erosion caused by livestock on waterside toe.	37.265180 ° -120.732745 °	37.265743 ° -120.733602 °	5 Y
DWR ID: DWR_NA0010_22A_s_2012_5										
9	4.81	4.84	Earthen Levee	Crown Surface / Depressions / Rutting	CR	M Ma	C3 : Add appropriate gravel or road base. Grade and compact.	37.265330 ° -120.732960 °	37.265705 ° -120.733553 °	10 Y
DWR ID: DWR_NA0010_22A_s_2012_10										
10	5.07	5.10	Earthen Levee	Crown Surface / Depressions / Rutting	CR	M Ma	C2 : Repair depressions or ruts in the crown or slope. Inspector Comments: Minor rutting on levee crown.	37.267682 ° -120.736597 °	37.267967 ° -120.736913 °	9 Y
DWR ID: DWR_NA0010_22A_s_2012_9										
11	5.09	5.09	Earthen Levee	Crown Surface / Depressions / Rutting	CR	M Ma	C2 : Repair depressions or ruts in the crown or slope.	37.267903 ° -120.736878 °	37.267903 ° -120.736878 °	57 Y

Looking north at waterside erosion from livestock.

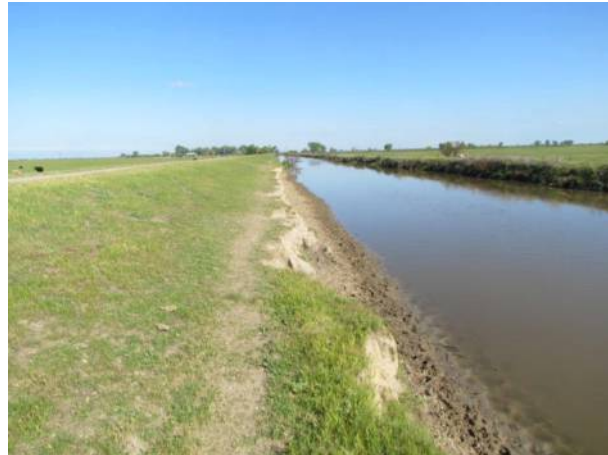
richard_f_20121101_106.jpg

Looking north at livestock erosion along waterside slope and toe.

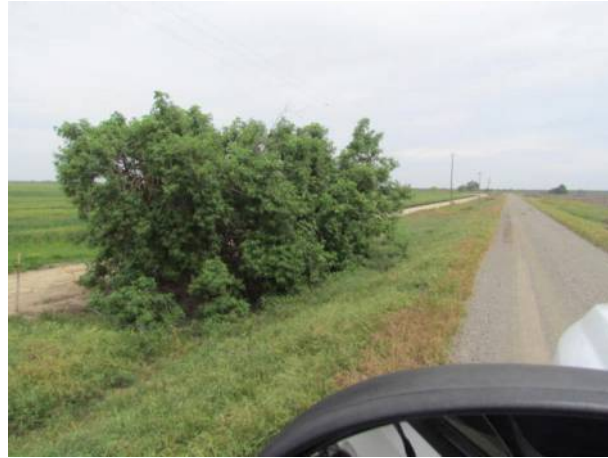
richard_f_20121101_115.jpg

Looking south at elderberry on landside toe and berm.

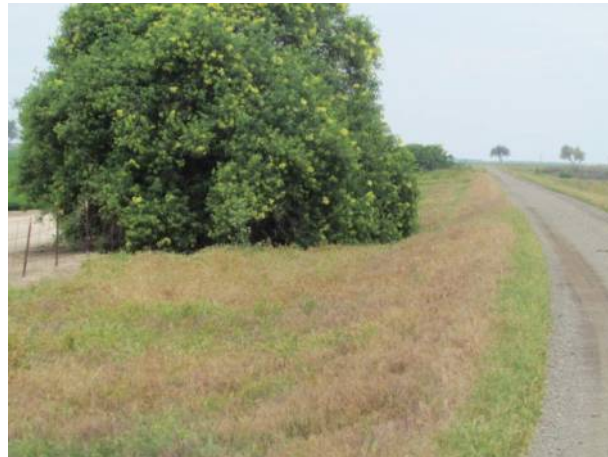
richard_f_20121101_109.jpg

Looking south at elderberry on landside toe and berm.

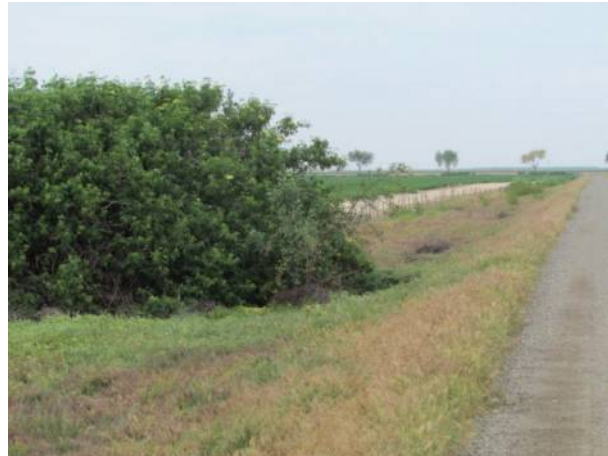
richard_f_20121101_112.jpg

Looking south at elderberry on landside toe and berm.

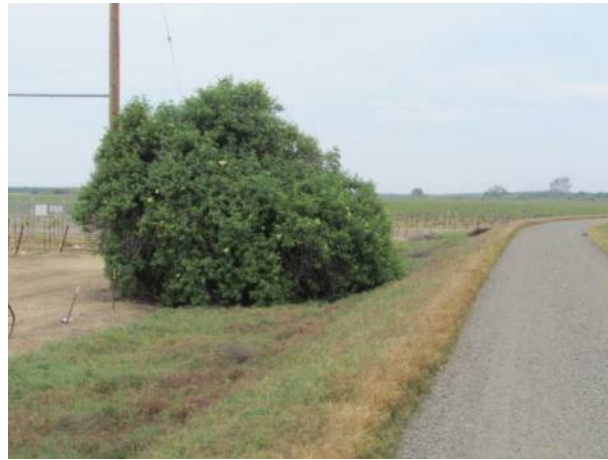
richard_f_20121101_113.jpg

Looking south at elderberry on landside toe and berm.

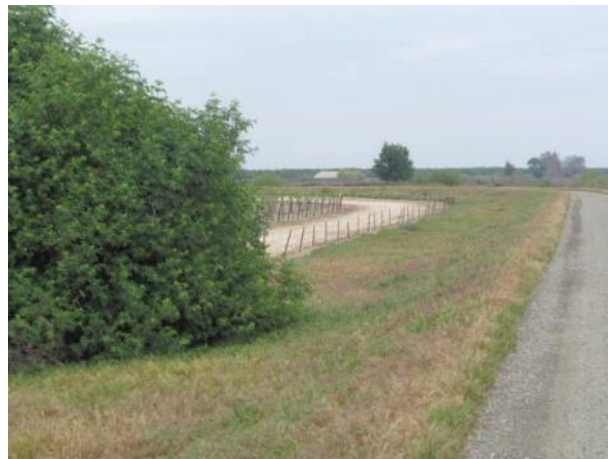
richard_f_20121101_114.jpg

Looking south at elderberry on landside toe and berm.

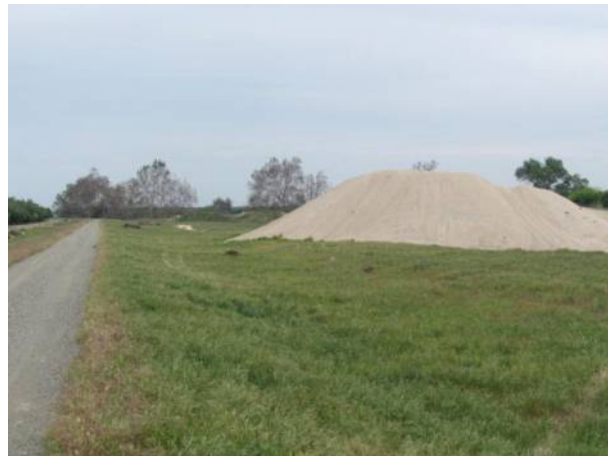
richard_f_20121101_111.jpg

Looking south at sand pile 20-30 feet away from waterside slope.

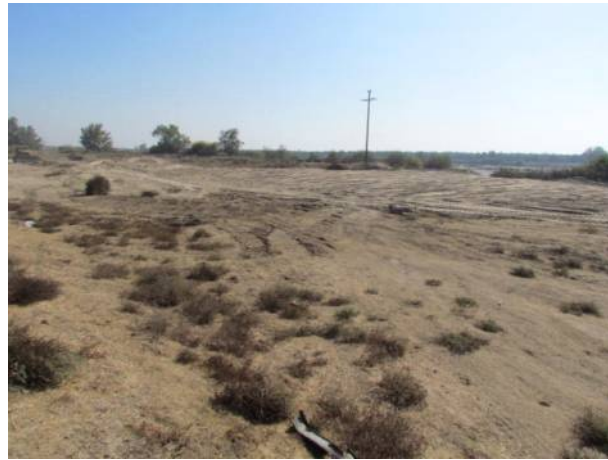
richard_f_20121115_891.JPG

Looking southwest at de-graded sandpile in channel.

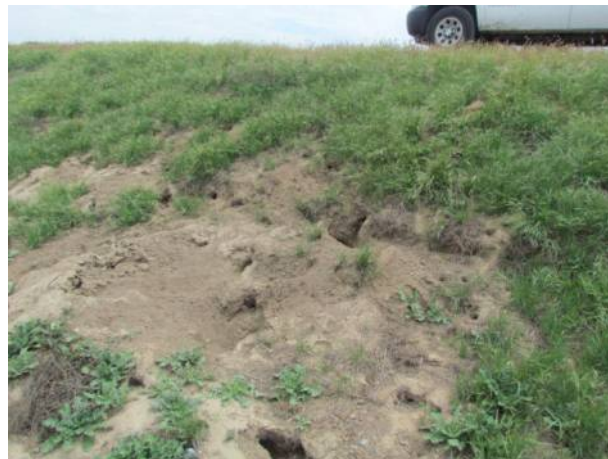
richard_f_20121101_110.jpg

Looking at several rodent holes on landside slope.

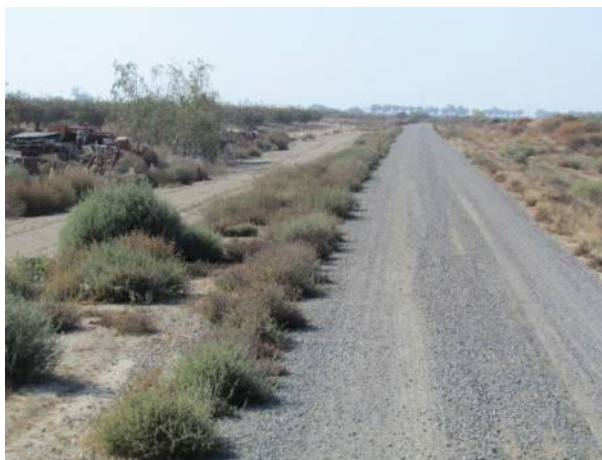
richard_f_20121115_893.JPG

Looking north at tumble weeds on landside and waterside slopes.

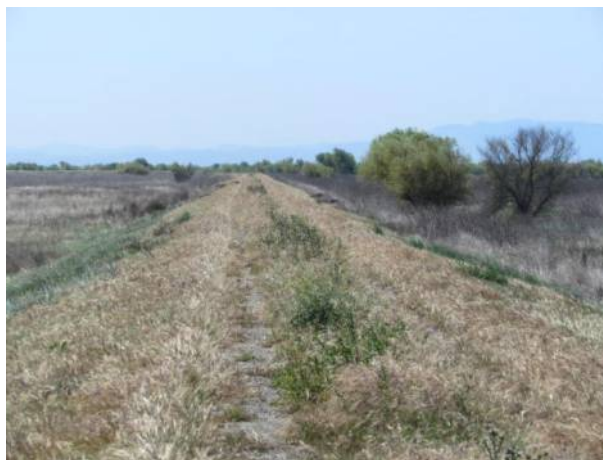
richard_f_20121101_116.jpg

Looking west at vegetation on levee crown.

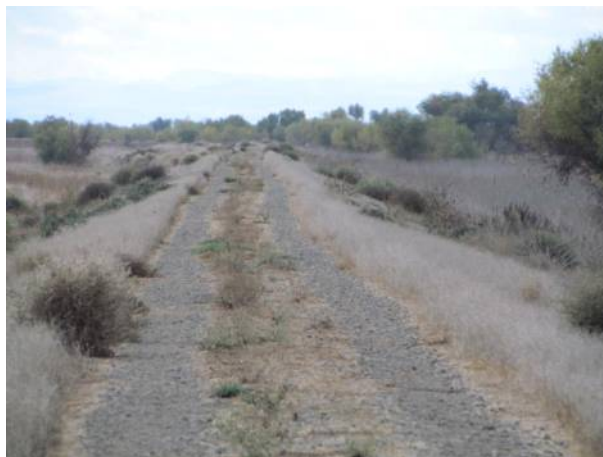
richard_f_20121115_910.JPG

Looking north at vegetation on levee crown.

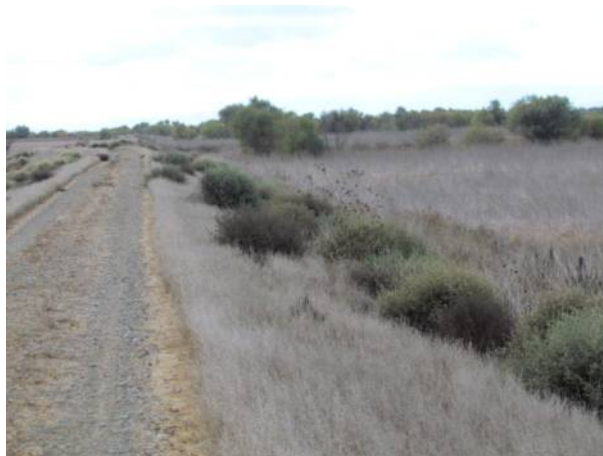
richard_f_20121115_911.JPG

Looking west at typical view of tumble weeds on levee slope.
