**Flood Control Project Maintenance
Levee Inspections**

Fall 2015 Levee Maintenance Deficiency Summary Report

San Joaquin River Basin

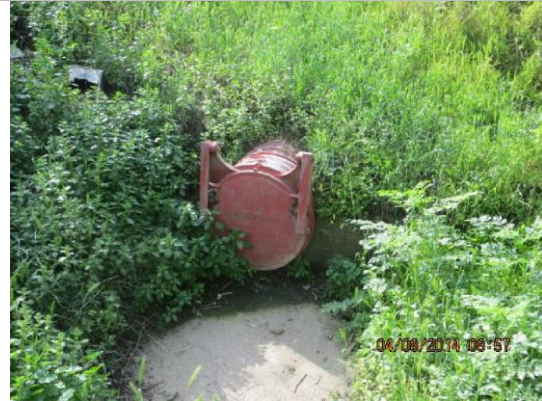
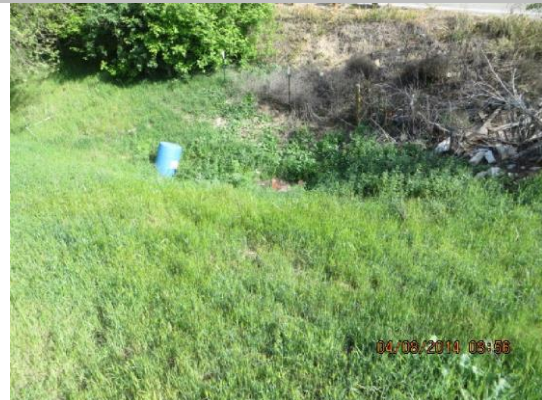
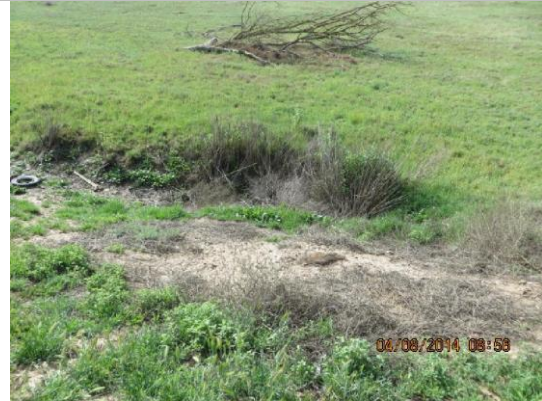
UCIP Comments: Dense vegetation limits the inspector's visibility to identify signs of pipe failure (leaks) along the waterward slope and landward toe. Recommend removing vegetation along pipe alignment and landward toe to conduct proper inspection of structure and appurtenances.

Flapgate on WS toe.

Headwall on LS toe.

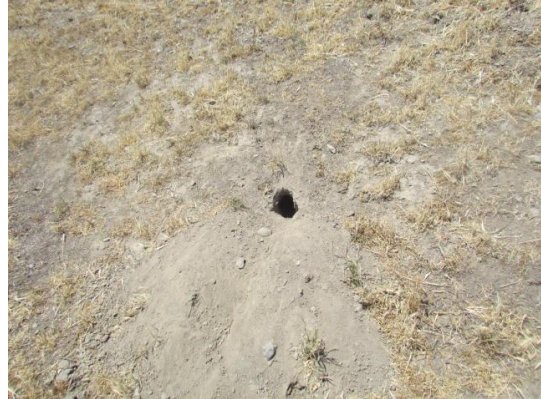
Photo 1 of 1 : FA_2015_NA0010_118_1_20150914_00001.jpg

LM Start	0.23	Rating **	M	Issue No.	1
LM End	0.39	Issue Type +	Ma	Location *	LS
Category	Earthen Levee			GPS Latitude/Longitude	
				Start	End
Item	Animal Control			37.346152 °	37.343935 °
				-120.961402 °	-120.962536 °
DWR ID	DWR_NA0010_01_s_2012_1				
Action/Comments					
Exterminate rodents and backfill and compact or grout burrows. Inspector Comments: Typical view of several rodent holes on landward slope.

Looking at typical rodent holes on landward slope.

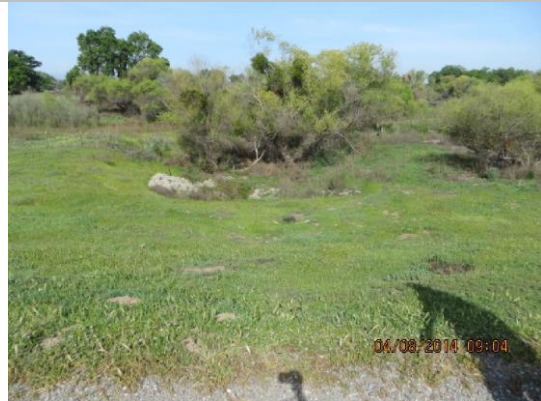
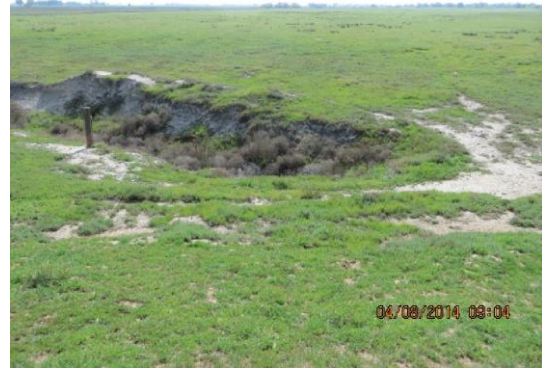
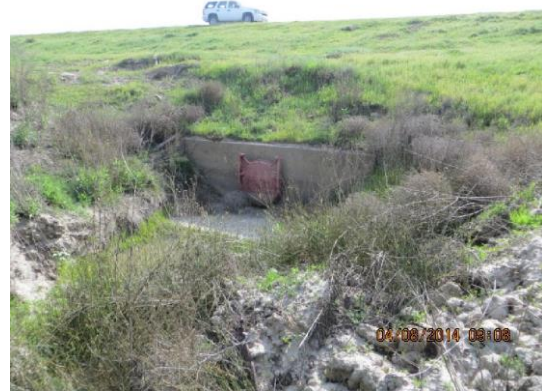
Flapgate and headwall visible off WS toe.

Inspector Comments: FS_ID:39092
 DS_ID:19651
 EP_NO: N/A
 FS_HLM: 0.352
 Repair Type: Non-Urgent
 Crossing Status: Found
 UCIP Comments: Pipe has significant sediment buildup and shows some signs of corrosion at landward toe. Recommend cleaning sediment from inside pipe and check wall integrity.
 FIELD_STRUCT_DESC: 36-inch CM stormdrain pipe through the levee, 18.5 feet below the crown. Flap gate on the waterward end. Brass cap No. 108 BM on headwall on the landward side. (USACE-1967). This entry matches the Drainage or Irrigation Structure referenced in O&M manual (HLM 0.35).
 FS Date: 04/08/2014

Pipe and headwall visible off LS toe.

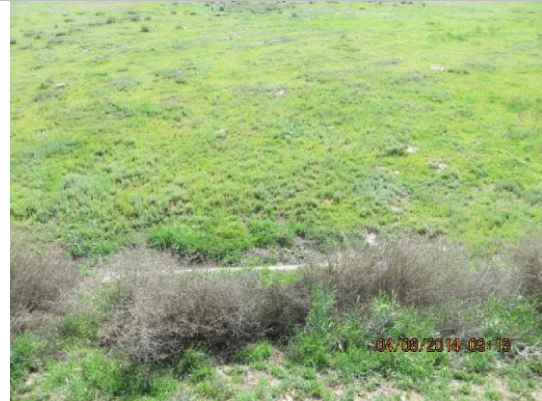
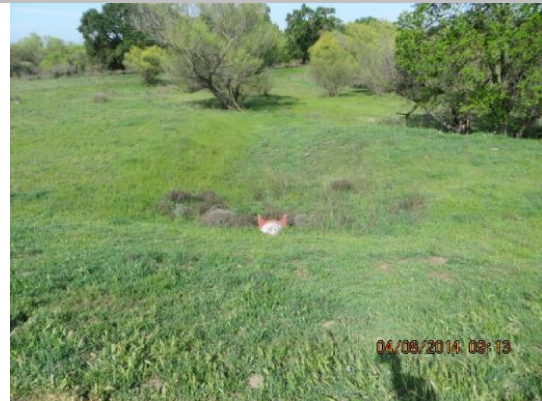
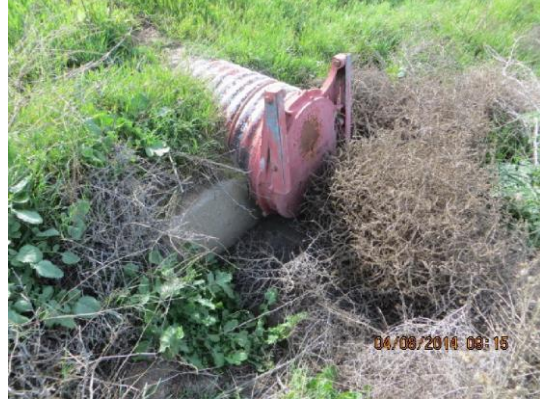
Pipe and headwall visible on LS toe.

Flapgate and headwall visible on WS toe.

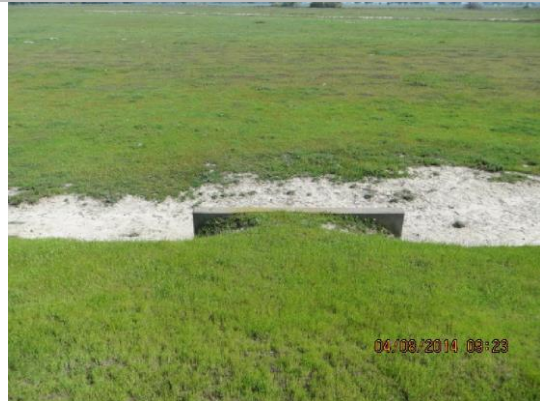
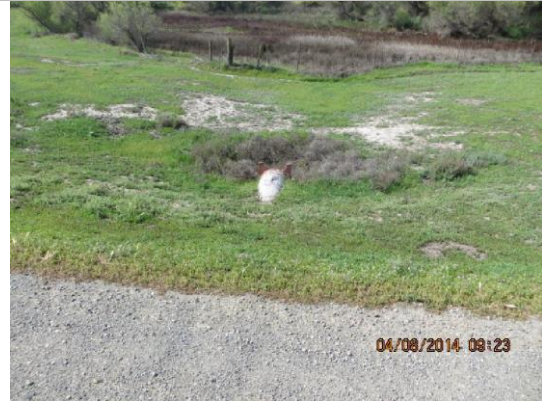
Concrete headwall and pipe visible at LS toe.

Inspector Comments: FS_ID:39096
 DS_ID:19585
 EP_NO: N/A
 FS_HLM: 0.943
 Repair Type: Non-Urgent
 Crossing Status: Found
 UCIP Comments: Moderate erosion around headwall on landward toe.
 May or may not be an issue. Need to contact owner to determine status
 of crossing and to address erosion issue on landward side.
 FIELD_STRUCT_DESC: 24-inch CM pipe through the levee, 7-feet
 below the crown. Flap gate on the waterward end. Brass cap No. 108
 BM on headwall on the landward side. (USACE-1967). This entry
 matches the Drainage or Irrigation Structure referenced in O&M manual
 (HLM 0.95).
 FS Date: 04/08/2014

Flapgate, pipe, and headwall on WS toe.

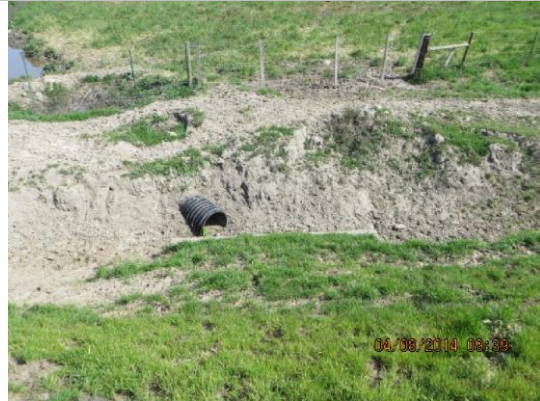
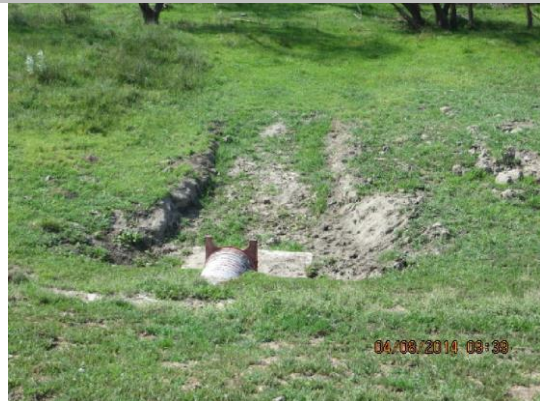
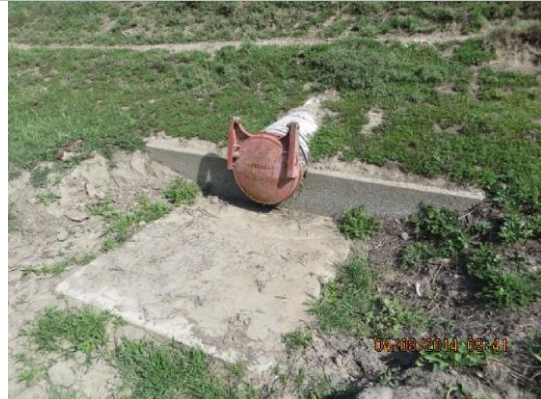
Pipe and concrete headwall visible on LS toe.

Pipe, flapgate, and concrete headwall visible on WS toe.

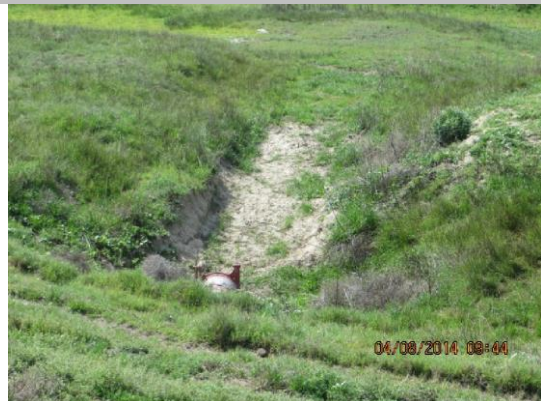
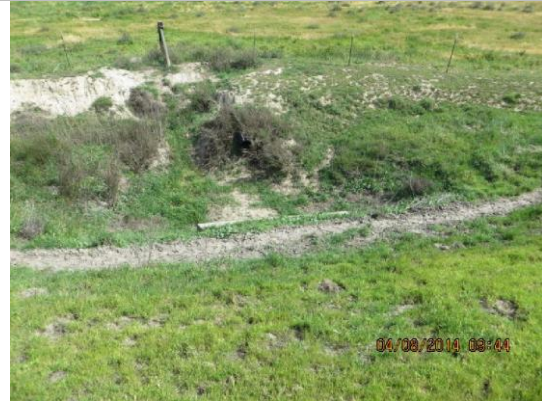
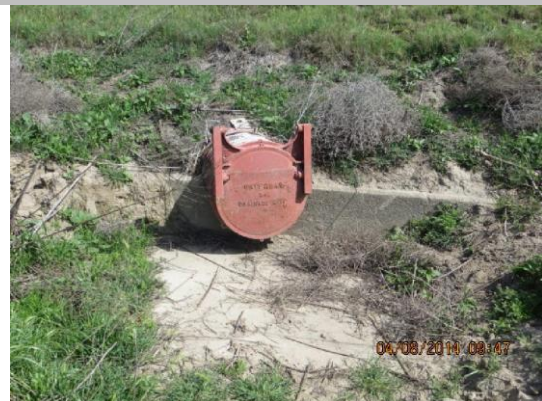
Pipe, headwall, and flapgate visible on WS toe.

Inspector Comments: FS_ID:33563
 DS_ID:19589
 EP_NO: N/A
 FS_HLM: 1.685
 Repair Type: Non-Urgent
 Crossing Status: Found
 UCIP Comments: Heavy sediment buildup in pipe at LS toe.
 FIELD_STRUCT_DESC: 24-inch CM stormdrain pipe through the levee, 13.6 feet below the crown. Flap gate on the waterward end.
 Brass cap No. 100 BM on headwall on the landward side. (USACE-1967). This entry matches the Drainage or Irrigation Structure referenced in O&M manual (HLM 1.69).
 FS Date: 04/08/2014

Pipe and headwall visible on LS toe.

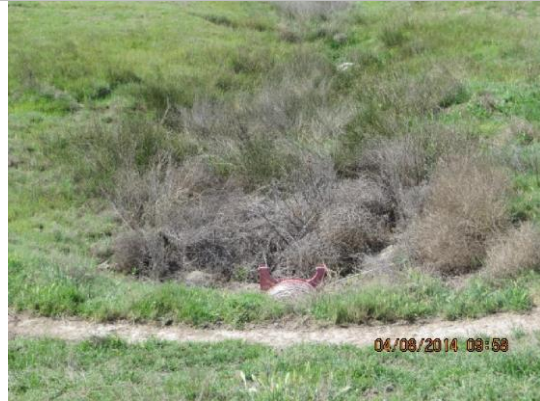
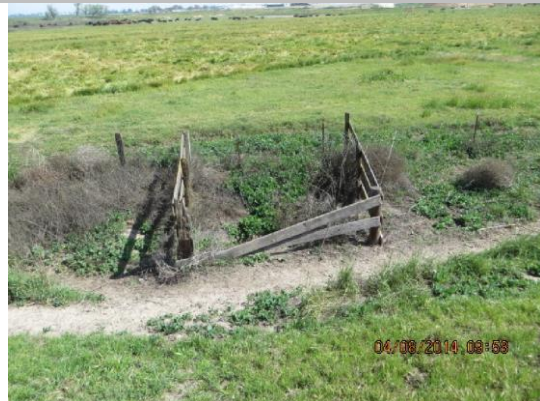
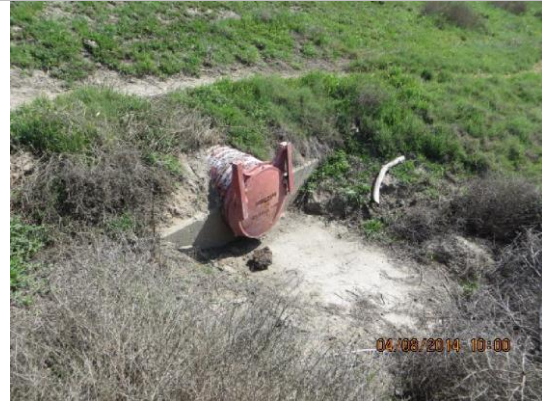
Concrete headwall and flapgate on WS toe.

Wooded barrier around drop-inlet on LS toe.

Pipe, flapgate, and headwall on WS toe.

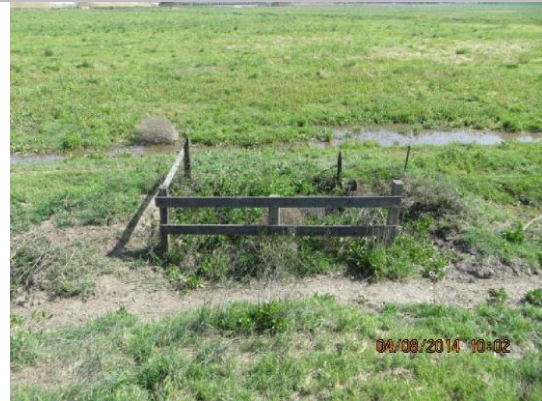
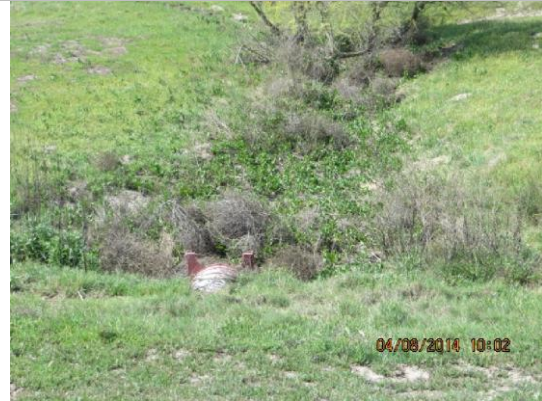
Wooded barrier around drop-inlet on LS toe.

Pipe and flapgate visible on WS toe.

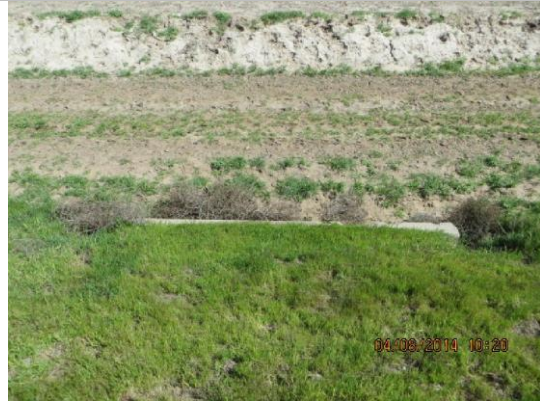
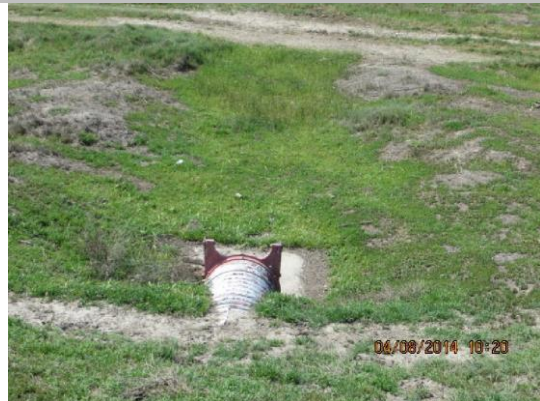
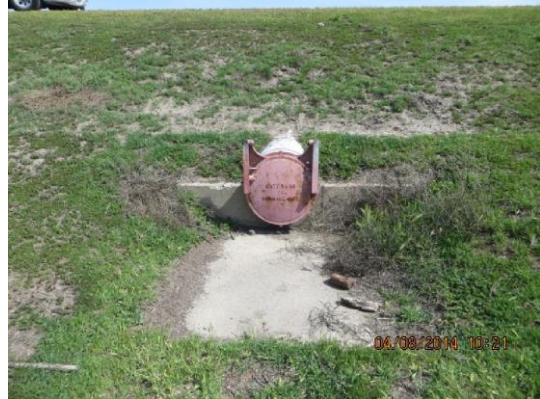
Pipe and headwall on LS toe.

Pipe, flapgate, and headwall on WS toe.

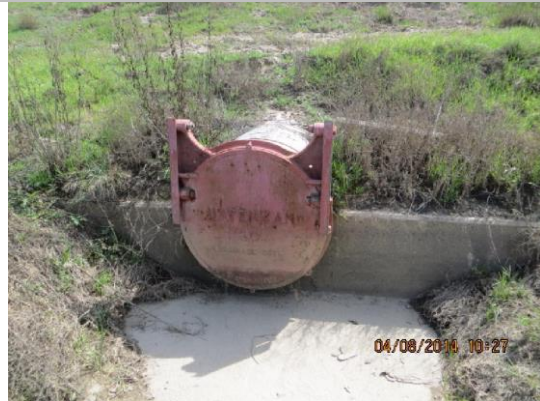
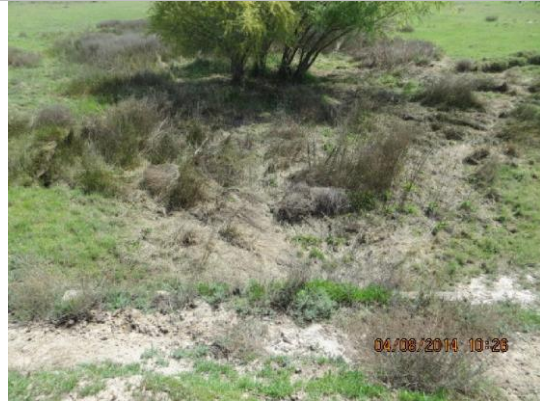
Pipe, Flapgate, and headwall on WS toe.

Action/Comments					
Inspector Comments: FS_ID:39128 DS_ID:19574 EP_NO: N/A FS_HLM: 3.156 Repair Type: Non-Urgent Crossing Status: Found UCIP Comments: Some minor erosion around headwall on LS toe. FIELD_STRUCT_DESC: 36-inch CM pipe through the levee, 8-feet below the crown. Flap gate on the waterward end. Brass cap No. 100 BM on headwall on the landward side. (USACE-1967). This entry matches the Drainage or Irrigation Structure referenced in O&M manual (HLM 3.16). FS Date: 04/08/2014

Pipe and headwall on LS toe.

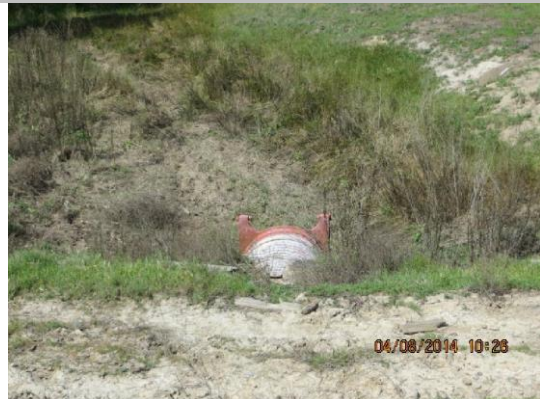
Photo 3 of 3 : UCIP_FA_2015_4332.jpg

Pipe, Flapgate, and headwall on WS toe.

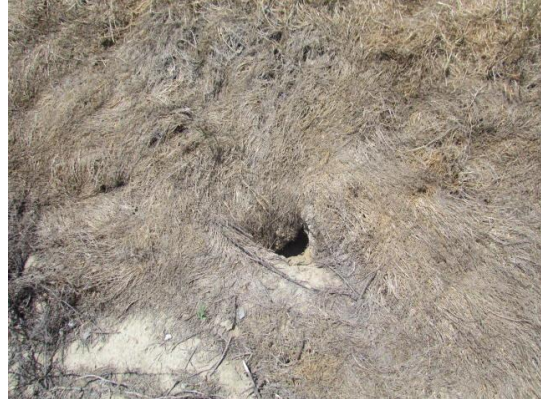
Photo 1 of 1 : FA_2015_NA0010_118_10_20150914_00009.jpg

LM Start	3.16	Rating **	M	Issue No.	10
LM End	3.16	Issue Type +	Ma	Location *	LS
Category	Earthen Levee			GPS Latitude/Longitude	
				Start	End
Item	Animal Control			37.321053 °	37.321053 °
				-120.928785 °	-120.928785 °
DWR ID	DWR_NA0010_01_s _ 2012_10				
Action/Comments					
No rodents visible, but rodent burrows visible; need to backfill and compact or grout burrows.					
Inspector Comments: Several rodent holes noted in this section.

Looking at typical view of rodent holes on landward slope.

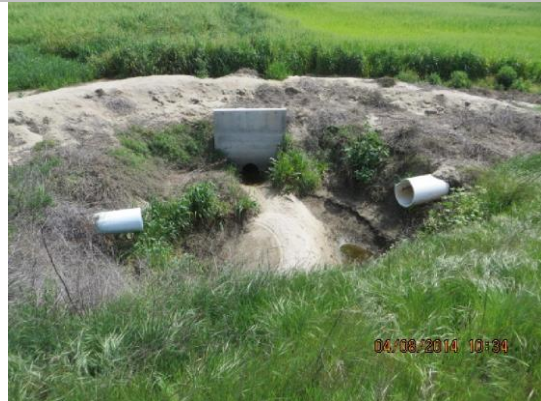
Photo 1 of 2 : UCIP_FA_2015_4333.jpg

Pipe and headwall on LS toe.

Inspector Comments: FS_ID:39130
DS_ID:19575
EP_NO: N/A
FS_HLM: 3.492
Repair Type: Urgent
Crossing Status: Found
UCIP Comments: Pipe rusted through at Springline on LS toe. Flapgate blocked by sediment on WS toe. Heavy sediment on both ends of pipe. Need to contact owner to address issues.
FIELD_STRUCT_DESC: 36-inch CM pipe, through the levee, 9.7 feet below the crown. Flap gate on the waterward end. Brass cap No. 100 BM on headwall on the landward side. (USACE-1967). This entry matches the Drainage or Irrigation Structure referenced in O&M manual (HLM 3.50).
FS Date: 04/08/2014

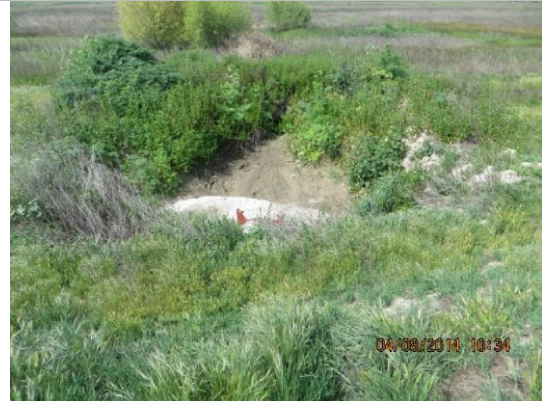
Photo 2 of 2 : UCIP_FA_2015_4334.jpg

Pipe, headwall, and flapgate on WS toe.

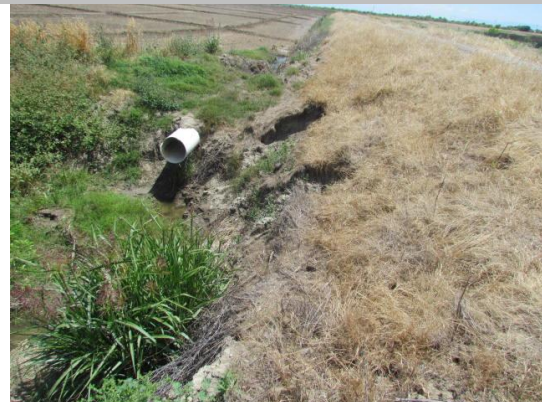
Photo 1 of 3 : FA_2015_NA0010_118_1179_20150914_00028.jpg

Note and monitor erosion site.
Inspector Comments: Several erosions greater than three inches on landward slope.

Looking south at erosion on landward slope and toe.

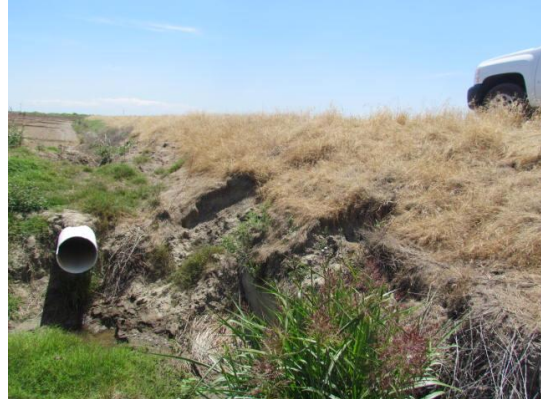
Photo 2 of 3 : FA_2015_NA0010_118_1179_20150914_00029.jpg

LM Start	3.47	Rating **	U	Issue No.	1179 (cont)
LM End	3.47	Issue Type +	Ma	Location *	LS
Category	Earthen Levee			GPS Latitude/Longitude	
				Start	End
Item	Erosion / Bank Caving			37.317057 °	37.317057 °
				-120.926443 °	-120.926443 °
DWR ID	DWR_NA0010_01_s _ 2015_1179				
Action/Comments					
Note and monitor erosion site. Inspector Comments: Several erosions greater than three inches on landward slope.

Looking southwest at erosion on landward slope and toe.

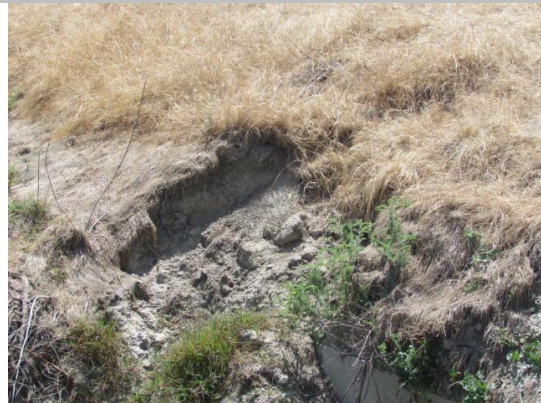
Photo 3 of 3 : FA_2015_NA0010_118_1179_20150914_00030.jpg

Looking west at erosion on landward slope and toe.

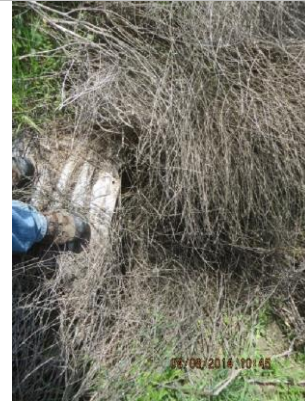
Photo 1 of 3 : UCIP_FA_2015_4335.jpg

Slide gate missing on WS toe with heavy vegetation camouflaging pipe

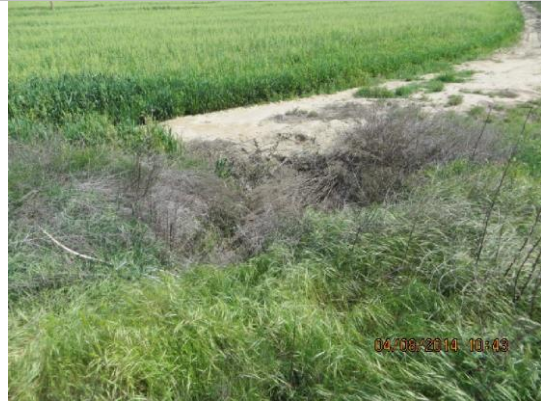
Photo 2 of 3 : UCIP_FA_2015_4336.jpg

Concrete headwall in heavy vegetation at LS toe.

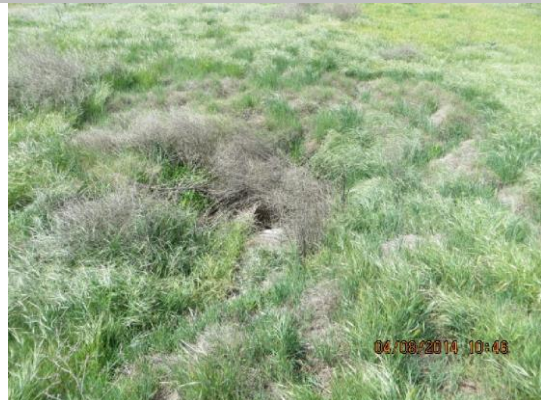
Photo 3 of 3 : UCIP_FA_2015_4337.jpg

Slide gate missing on WS toe with heavy vegetation camouflaging pipe

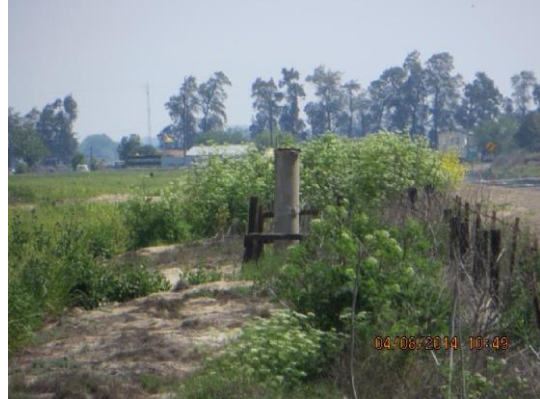
Photo 1 of 2 : UCIP_FA_2015_4338.jpg

12-inch concrete standpipe off LS toe.

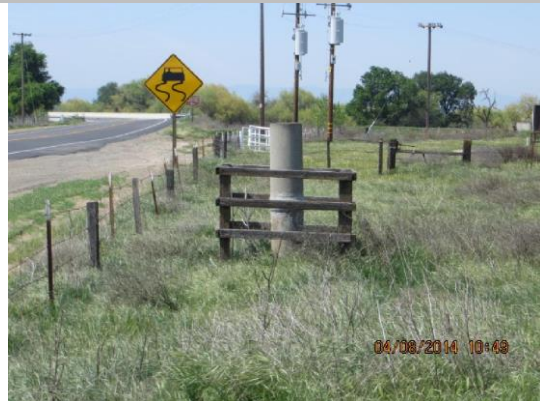
Photo 2 of 2 : UCIP_FA_2015_4339.jpg

12-inch concrete standpipe off WS toe.

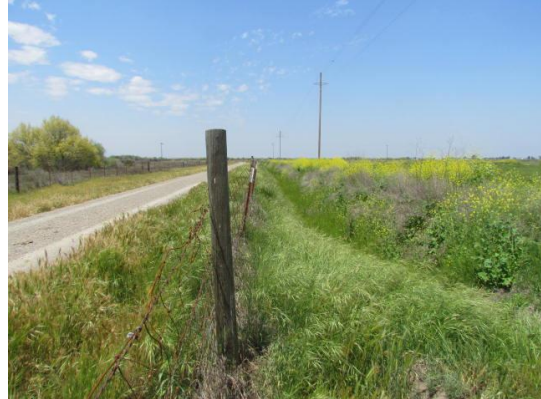
Photo 1 of 2 : FA_2015_NA0010_118_5_20150914_00002.jpg

LM Start	3.98	Rating **	U	Issue No.	5
LM End	4.05	Issue Type +	En	Location *	LS
Category	Earthen Levee			GPS Latitude/Longitude	
				Start	End
Item	Encroachments			37.310837 °	37.310003 °
				-120.926182 °	-120.925313 °
DWR ID	DWR_NA0010_01_s_2012_5				
Action/Comments					
Ditch					
Inspector Comments: Irrigation ditch at landside toe

Looking north at irrigation ditch at landside toe.

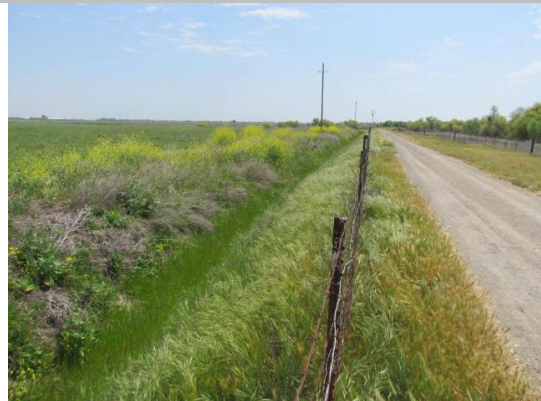
Photo 2 of 2 : FA_2015_NA0010_118_5_20150914_00003.jpg

Looking south at irrigation ditch at landside toe.

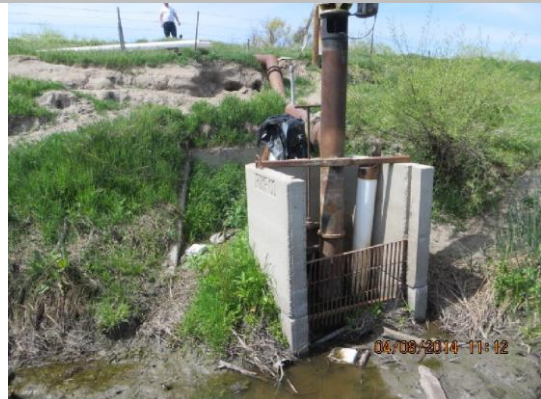
Photo 1 of 3 : UCIP_FA_2015_4340.jpg

Concrete inlet, slidegate, and concrete headwall at LS toe.

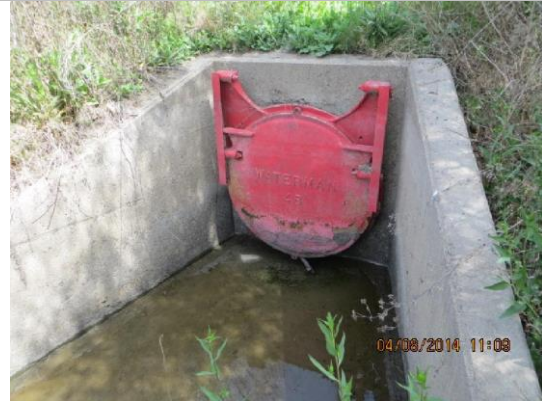
Photo 2 of 3 : UCIP_FA_2015_4341.jpg

Concrete headwall and 48-inch flapgate visible on WS toe.

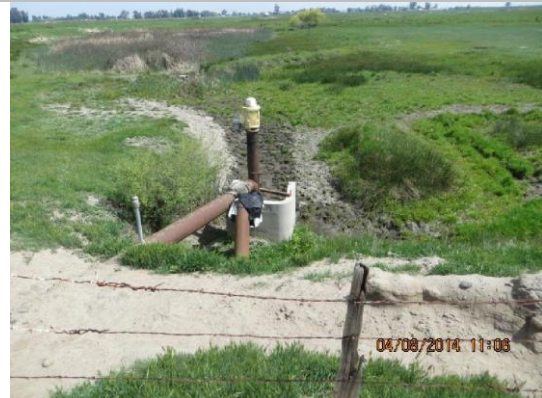
Photo 3 of 3 : UCIP_FA_2015_4342.jpg

Assumed pipe exists under pump at LS toe.

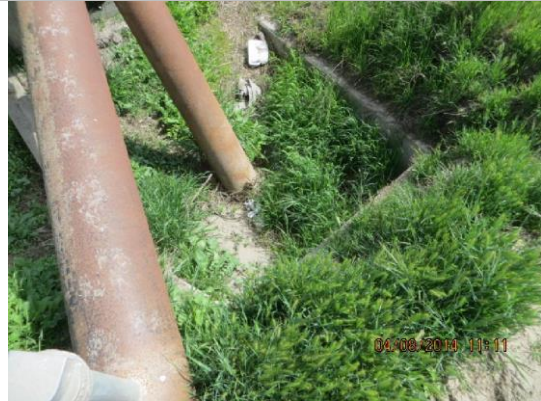
Photo 1 of 2 : UCIP_FA_2015_6122.jpg

Pipe through existing 48 inch pipe.

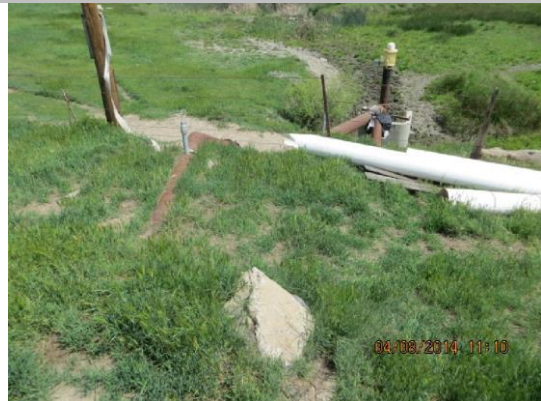
Photo 2 of 2 : UCIP_FA_2015_6123.jpg

View of pipe visible on landward side.

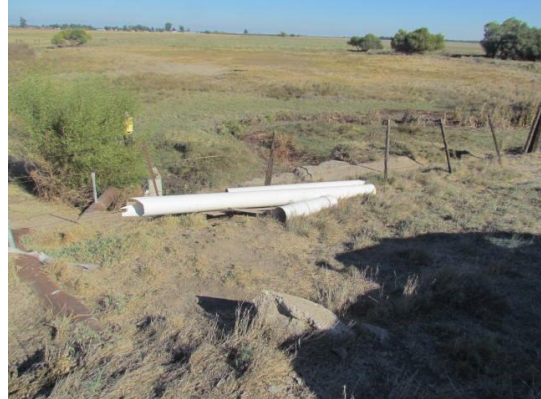
Photo 1 of 1 : FA_2015_NA0010_118_100_20150914_00021.jpg

LM Start	4.13	Rating **	M	Issue No.	100
LM End	4.13	Issue Type +	Ma	Location *	LS
Category	Earthen Levee			GPS Latitude/Longitude	
				Start	End
Item	Encroachments			37.309049 °	37.309049 °
				-120.924421 °	-120.924421 °
DWR ID	DWR_NA0010_01_f _ 2014_100				
Action/Comments					
Garbage					
Inspector Comments: Old PVC pipes left on landward slope.

Looking east at old pvc pipes on landward slope.

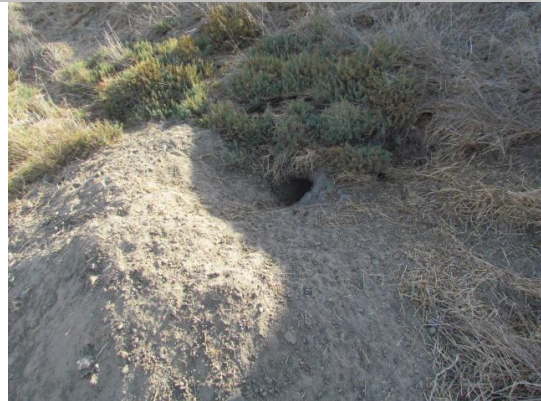
Photo 1 of 2 : FA_2015_NA0010_118_6_20151012_00033.jpg

LM Start	4.18	Rating **	U	Issue No.	6
LM End	4.18	Issue Type +	Ma	Location *	LS
Category	Earthen Levee			GPS Latitude/Longitude	
				Start	End
Item	Animal Control			37.308540 °	37.308540 °
				-120.924003 °	-120.924003 °
DWR ID	DWR_NA0010_01_s_2012_6				
Action/Comments					
Exterminate rodents and backfill and compact or grout burrows. Inspector Comments: Several rodent holes noted in this section.

Looking at typical rodent holes within the section (Fall 2015)

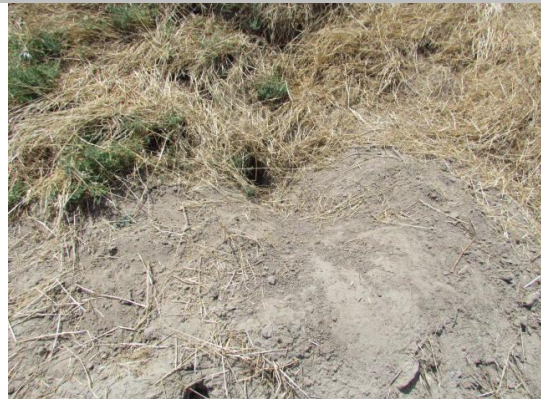
Photo 2 of 2 : FA_2015_NA0010_118_6_20150914_00004.jpg

Looking at typical rodent holes within this section. (Spring 2015)

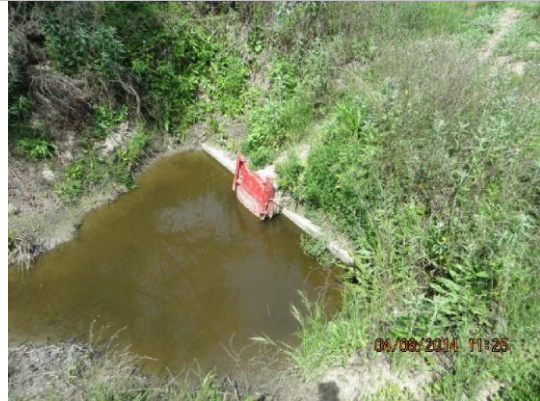
Photo 1 of 3 : UCIP_FA_2015_4415.jpg

Pipe, flapgate, and headwall visible at WS toe.

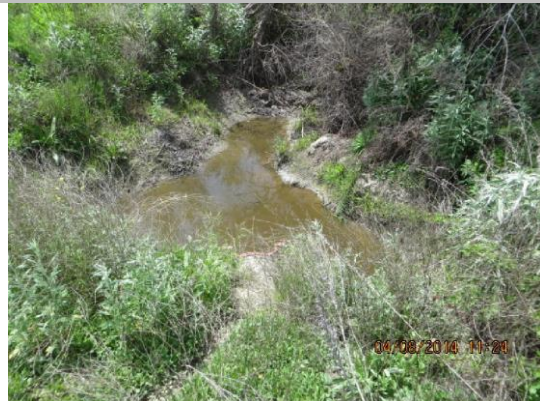
Photo 2 of 3 : UCIP_FA_2015_4416.jpg

Pipe, flapgate, and headwall visible at WS toe.

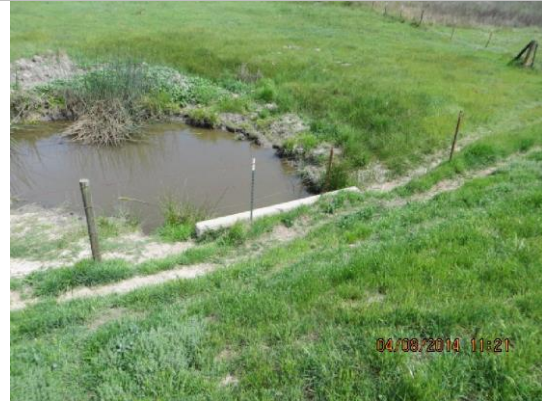
Photo 3 of 3 : UCIP_FA_2015_4417.jpg

Concrete headwall at LS toe.

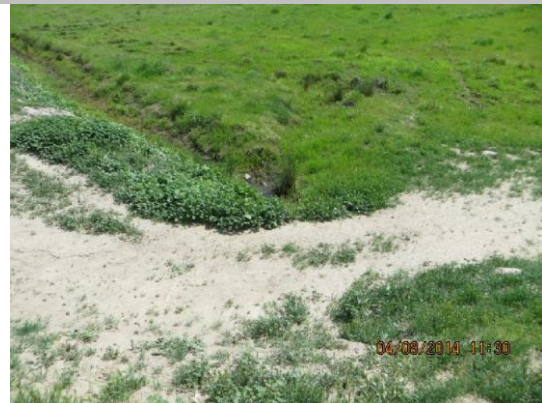
Photo 1 of 3 : UCIP_FA_2015_4418.jpg

Pipe and concrete headwall on LS toe.

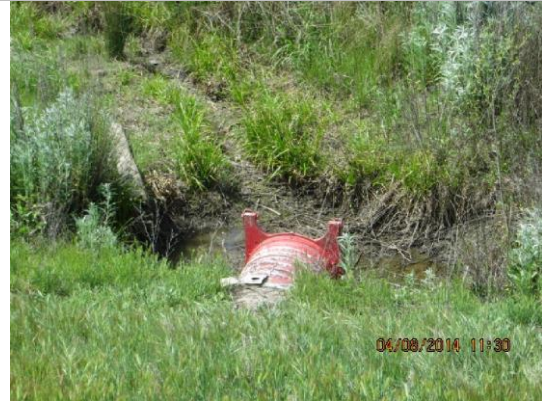
Photo 2 of 3 : UCIP_FA_2015_4419.jpg

Pipe, flapgate, and headwall on WS toe.

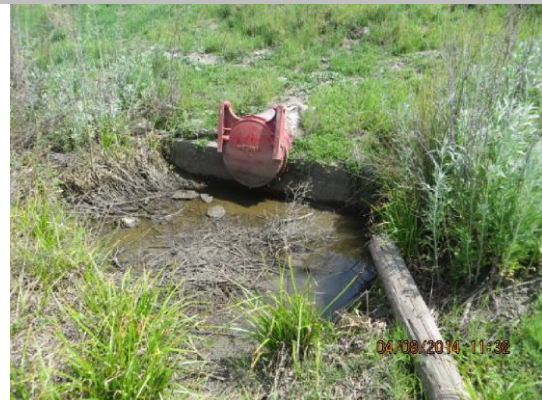
Photo 3 of 3 : UCIP_FA_2015_4420.jpg

Pipe, flapgate, and headwall on WS toe.

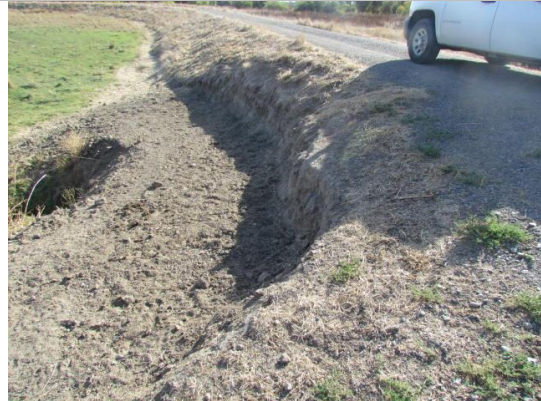
Photo 1 of 1 : FA_2015_NA0010_118_9_20151012_00034.jpg

LM Start	4.69	Rating **	U	Issue No.	9
LM End	4.69	Issue Type +	Ma	Location *	LS
Category	Earthen Levee			GPS Latitude/Longitude	
				Start	End
Item	Animal Control			37.302398 °	37.302398 °
				-120.920920 °	-120.920920 °
DWR ID	DWR_NA0010_01_s _ 2013_9				
Action/Comments					
Repair the levee slope damaged by livestock and prevent large animal access.					
Inspector Comments: Levee landward toe damaged by livestock.

Looking at landward slope damaged by livestock.

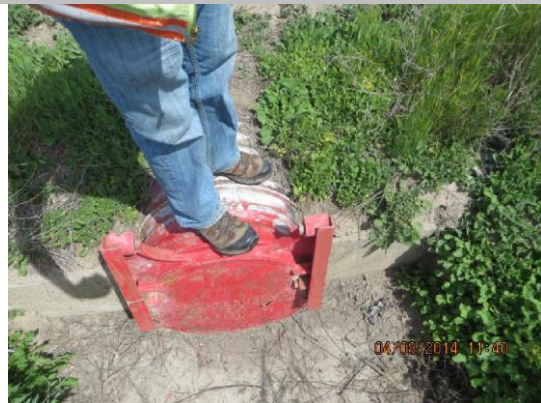
Photo 1 of 2 : UCIP_FA_2015_4421.jpg

LM Start	5.02	Rating **	M	Issue No.	1202
LM End	5.02	Issue Type +	En	Location *	LS
Category	Supplemental			GPS Latitude/Longitude	
				Start	End
Item	DWR UCIP Field Study			37.298917 °	37.298917 °
				-120.917262 °	-120.917262 °
DWR ID					
Action/Comments					
Inspector Comments: FS_ID:39143 DS_ID:19610 EP_NO: N/A FS_HLM: 5.05 Repair Type: Non-Urgent Crossing Status: Found UCIP Comments: Non-functional -- sediment buildup against flapgate and inlet buried at landward side. FIELD_STRUCT_DESC: 24-inch CM stormdrain pipe through the levee, 8.0 feet below the crown. Flap gate on the waterward end. Brass cap No. 90 BM on headwall on the landward side. (USACE-1967). This entry matches the Drainage or Irrigation Structure referenced in O&M manual (HLM 5.05). FS Date: 04/08/2014

Flapgate and headwall visible at WS toe.

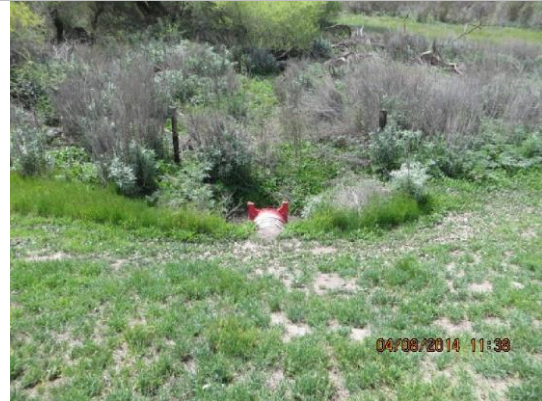
Photo 2 of 2 : UCIP_FA_2015_4422.jpg

LM Start	5.02	Rating **	M	Issue No.	1202 (cont)
LM End	5.02	Issue Type +	En	Location *	LS
Category	Supplemental			GPS Latitude/Longitude	
				Start	End
Item	DWR UCIP Field Study			37.298917 °	37.298917 °
				-120.917262 °	-120.917262 °
DWR ID					
Action/Comments					
Inspector Comments: FS_ID:39143 DS_ID:19610 EP_NO: N/A FS_HLM: 5.05 Repair Type: Non-Urgent Crossing Status: Found UCIP Comments: Non-functional -- sediment buildup against flapgate and inlet buried at landward side. FIELD_STRUCT_DESC: 24-inch CM stormdrain pipe through the levee, 8.0 feet below the crown. Flap gate on the waterward end. Brass cap No. 90 BM on headwall on the landward side. (USACE-1967). This entry matches the Drainage or Irrigation Structure referenced in O&M manual (HLM 5.05). FS Date: 04/08/2014

Flapgate and headwall visible at WS toe.

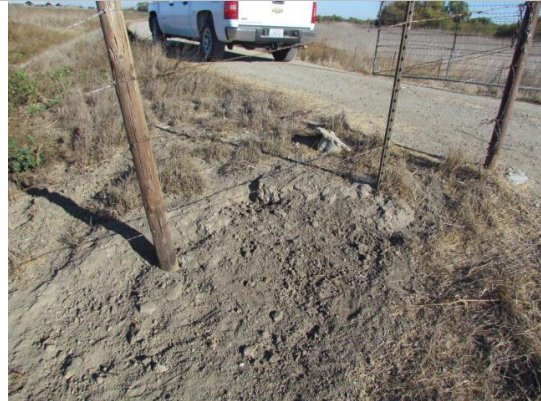
Photo 2 of 3 : FA_2015_NA0010_118_116_20150914_00023.jpg

LM Start	5.72	Rating **	A/W	Issue No.	116 (cont)
LM End	5.72	Issue Type +	Ma	Location *	LS
Category	Earthen Levee			GPS Latitude/Longitude	
				Start	End
Item	Animal Control			37.304057 °	37.304057 °
				-120.907200 °	-120.907200 °
DWR ID	DWR_NA0010_01_s _ 2012_116				
Action/Comments					
No rodents visible, but rodent burrows visible; need to backfill and compact or grout burrows. Inspector Comments: Large rodent holes on landside slope near fence pole have been repaired. Monitor area for new activity.

Looking south at repaired rodent site on landside slope. (Fall 2012)

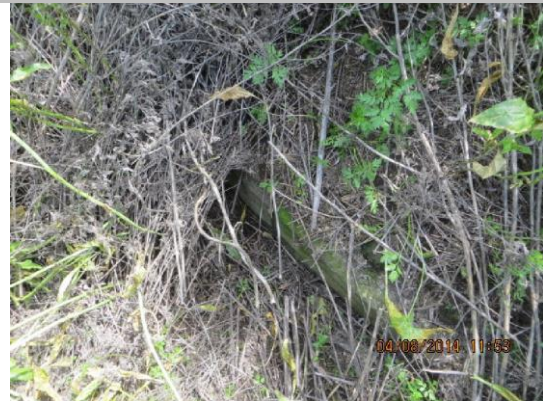
Photo 1 of 2 : UCIP_FA_2015_4493.jpg

LM Start	5.92	Rating **	M	Issue No.	1203
LM End	5.92	Issue Type +	En	Location *	LS
Category	Supplemental			GPS Latitude/Longitude	
				Start	End
Item	DWR UCIP Field Study			37.303612 °	37.303612 °
				-120.903704 °	-120.903704 °
DWR ID					
Action/Comments					
Inspector Comments: FS_ID:39151 DS_ID:19611 EP_NO: N/A FS_HLM: 5.953 Repair Type: Non-Urgent Crossing Status: Found UCIP Comments: Dense vegetation limits the inspector's visibility to identify signs of pipe failure (leaks) along waterward and landward slopes. Recommend removing vegetation along pipe alignment to conduct proper inspection of structure and appurtenances. Landward side filled in with soil. Need to contact owner. If crossing is no longer used need to coordinate with CVFPB for proper abandonment. FIELD_STRUCT_DESC: 24-inch CM stormdrain pipe through the levee, 8.6 feet below the crown. Flap gate on the waterward end. Brass cap No. 90 BM on headwall on the landward side. (USACE-1967). This entry matches the Drainage or Irrigation Structure referenced in O&M manual (HLM 5.95). FS Date: 04/08/2014

Top of concrete headwall just visible on LS toe.

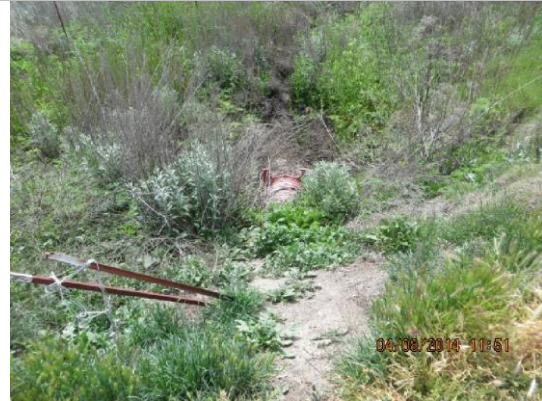
Photo 2 of 2 : UCIP_FA_2015_4494.jpg

Action/Comments					
Inspector Comments: FS_ID:39151					
DS_ID:19611					
EP_NO: N/A					
FS_HLM: 5.953					
Repair Type: Non-Urgent					
Crossing Status: Found					
UCIP Comments: Dense vegetation limits the inspector's visibility to identify signs of pipe failure (leaks) along waterward and landward slopes. Recommend removing vegetation along pipe alignment to conduct proper inspection of structure and appurtenances. Landward side filled in with soil. Need to contact owner. If crossing is no longer used need to coordinate with CVFPB for proper abandonment.					
FIELD_STRUCT_DESC: 24-inch CM stormdrain pipe through the levee, 8.6 feet below the crown. Flap gate on the waterward end. Brass cap No. 90 BM on headwall on the landward side. (USACE-1967). This entry matches the Drainage or Irrigation Structure referenced in O&M manual (HLM 5.95).					
FS Date: 04/08/2014

Pipe, concrete headwall, and flapgate visible on WS toe.

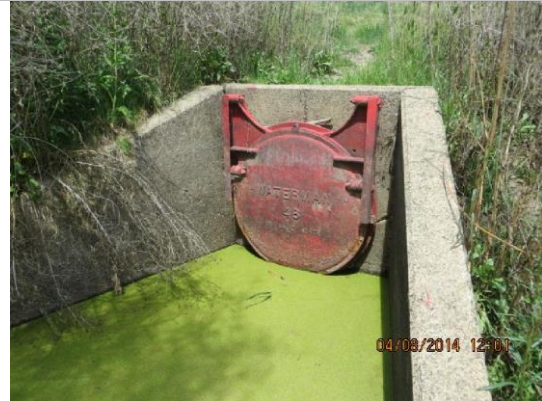
Photo 1 of 3 : UCIP_FA_2015_4495.jpg

UCIP Comments: Dense vegetation limits the inspector's visibility to identify signs of pipe failure (leaks) along waterward and landward slopes. Recommend removing vegetation along pipe alignment to conduct proper inspection of structure and appurtenances. Pipe completely blocked by soil on LS toe due to animal activity. Slide gate blocked open.

Flapgate on concrete headwall at WS toe.

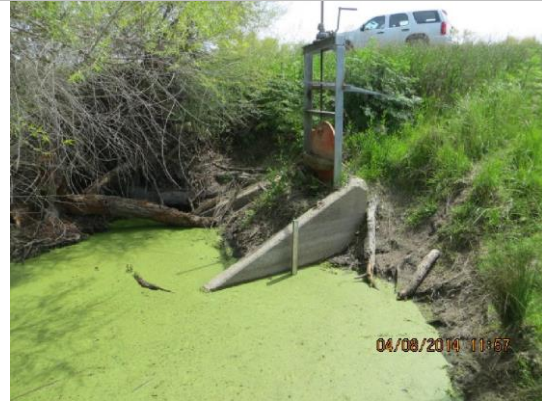
Photo 2 of 3 : UCIP_FA_2015_4496.jpg

UCIP Comments: Dense vegetation limits the inspector's visibility to identify signs of pipe failure (leaks) along waterward and landward slopes. Recommend removing vegetation along pipe alignment to conduct proper inspection of structure and appurtenances. Pipe completely blocked by soil on LS toe due to animal activity. Slide gate blocked open.

Pipe, concrete headwall, slidegate, and metal walkway on LS toe.

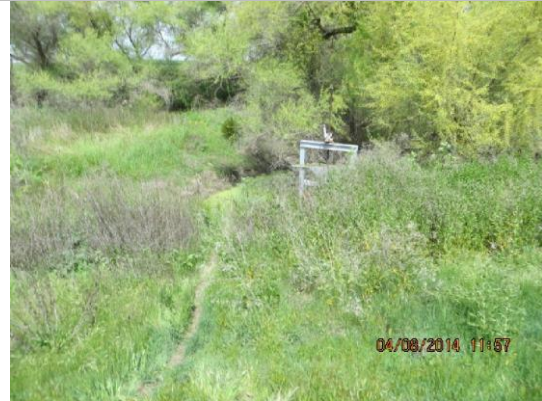
Photo 3 of 3 : UCIP_FA_2015_4533.jpg

Item	DWR UCIP Field Study			37.304232 °	37.304232 °	
				-120.900706 °	-120.900706 °	
DWR ID						
Action/Comments						
Inspector Comments: FS_ID:39152 DS_ID:19612 EP_NO: N/A FS_HLM: 6.128 Repair Type: Non-Urgent Crossing Status: Found UCIP Comments: Dense vegetation limits the inspector's visibility to identify signs of pipe failure (leaks) along waterward and landward slopes. Recommend removing vegetation along pipe alignment to conduct proper inspection of structure and appurtenances. Pipe completely blocked by soil on LS toe due to animal activity. Slide gate blocked open. FIELD_STRUCT_DESC: 48-inch CM pipe through the levee, 13.1 feet below the crown. Walkway to slidegate on LS toe at concrete headwall. Flap gate at concrete headwall on the WS toe. Brass cap No. 90 BM on headwall on the landward side. (USACE-1967). Pipe crosses levee at an angle to levee alignment. This entry matches the Drainage or Irrigation Structure referenced in O&M manual (HLM 6.13). FS Date: 04/08/2014

Slidegate at LS toe.

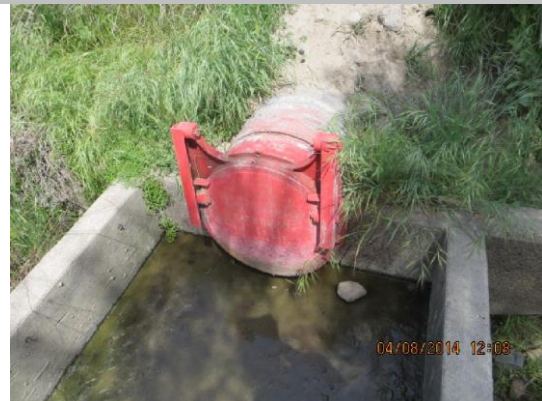
Photo 1 of 3 : UCIP_FA_2015_4534.jpg

LM Start	6.39	Rating **	M	Issue No.	1205
LM End	6.39	Issue Type +	En	Location *	LS
Category	Supplemental			GPS Latitude/Longitude	
				Start	End
Item	DWR UCIP Field Study			37.304459 °	37.304459 °
				-120.895863 °	-120.895863 °
DWR ID					
Action/Comments					
Inspector Comments: FS_ID:39154 DS_ID:19613 EP_NO: N/A FS_HLM: 6.42 Repair Type: Non-Urgent Crossing Status: Found UCIP Comments: Dense vegetation limits the inspector's visibility to identify signs of pipe failure (leaks) along the slope. Recommend removing vegetation along pipe alignment to conduct proper inspection of structure and appurtenances. FIELD_STRUCT_DESC: 24-inch CM stormdrain pipe through the levee, 9.5 feet below the crown. Flap gate on the waterward end. Slide gate on the landward end next to 48-inch concrete riser with walkway over its top. Brass cap No. 90 BM on headwall on the landward side. (USACE-1967). This entry matches the Drainage or Irrigation Structure referenced in O&M manual (HLM 6.40). FS Date: 04/08/2014

Pipe, flapgate, and concrete headwall on WS toe.

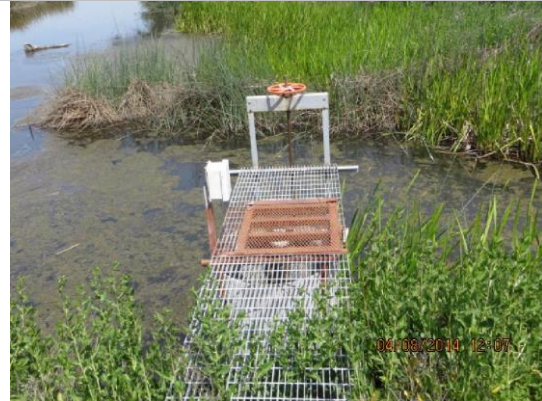
Photo 2 of 3 : UCIP_FA_2015_4535.jpg

Inspector Comments: FS_ID:39154
 DS_ID:19613
 EP_NO: N/A
 FS_HLM: 6.42
 Repair Type: Non-Urgent
 Crossing Status: Found
 UCIP Comments: Dense vegetation limits the inspector's visibility to identify signs of pipe failure (leaks) along the slope. Recommend removing vegetation along pipe alignment to conduct proper inspection of structure and appurtenances.
 FIELD_STRUCT_DESC: 24-inch CM stormdrain pipe through the levee, 9.5 feet below the crown. Flap gate on the waterward end. Slide gate on the landward end next to 48-inch concrete riser with walkway over its top. Brass cap No. 90 BM on headwall on the landward side. (USACE-1967). This entry matches the Drainage or Irrigation Structure referenced in O&M manual (HLM 6.40).
 FS Date: 04/08/2014

Metal walkway over concrete standpipe next to slide gate on LS toe.

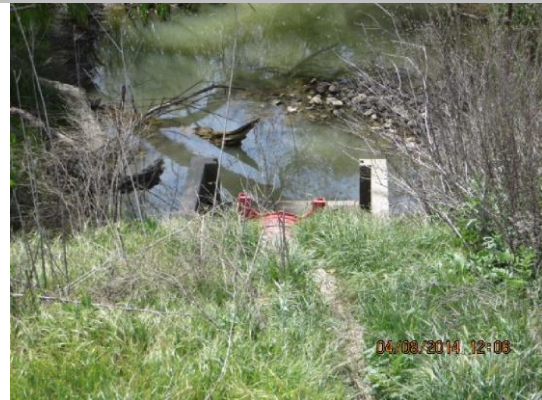
Photo 3 of 3 : UCIP_FA_2015_4536.jpg

Pipe, flapgate, and concrete headwall on WS toe.

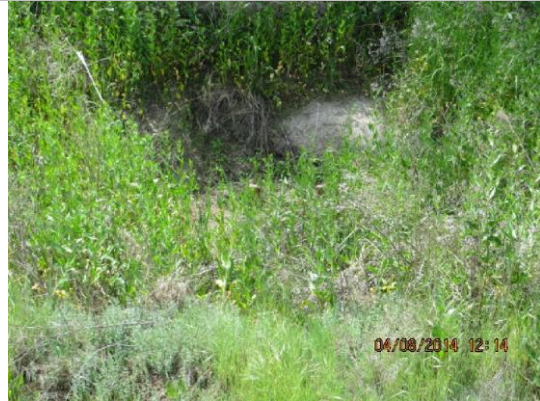
Photo 1 of 3 : UCIP_FA_2015_4537.jpg

LM Start	6.61	Rating **	U	Issue No.	1206
LM End	6.61	Issue Type +	En	Location *	LS
Category	Supplemental			GPS Latitude/Longitude	
				Start	End
Item	DWR UCIP Field Study			37.303815 °	37.303815 °
				-120.891955 °	-120.891955 °
DWR ID					
Action/Comments					
Inspector Comments: FS_ID:41134 DS_ID:19614 EP_NO: N/A FS_HLM: 6.65 Repair Type: Urgent Crossing Status: Found

Pipe and flapgate visible on WS toe.

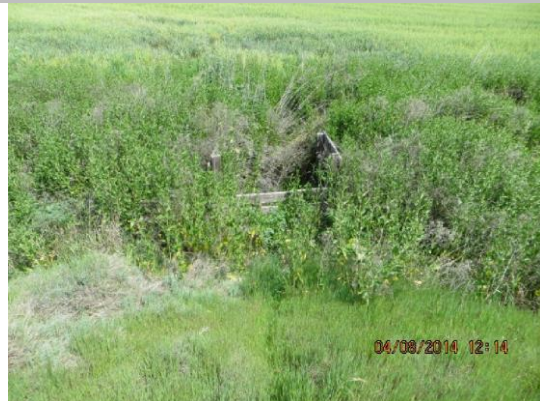
Photo 2 of 3 : UCIP_FA_2015_4538.jpg

Wooden barrier around drop inlet on LS toe. Excess vegetation.

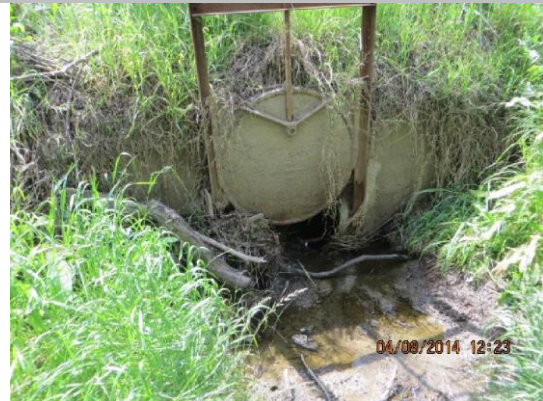
Photo 1 of 2 : UCIP_FA_2015_4540.jpg

LM Start	6.86	Rating **	U	Issue No.	1207
LM End	6.86	Issue Type +	En	Location *	LS
Category	Supplemental			GPS Latitude/Longitude	
				Start	End
Item	DWR UCIP Field Study			37.302098 °	37.302098 °
				-120.887943 °	-120.887943 °
DWR ID					
Action/Comments					
Inspector Comments: FS_ID:42850 DS_ID:19615 EP_NO: N/A FS_HLM: 6.897 Repair Type: Urgent Crossing Status: Found UCIP Comments: Slide gate blocked by debris at LS toe. Flapgate won't close because of debris. Dense vegetation limits the inspector's visibility to identify signs of pipe failure (leaks) along the slope. Recommend removing vegetation along pipe alignment to conduct proper inspection of structure and appurtenances. FIELD_STRUCT_DESC: 36-inch CM stormdrain pipe through the levee, 10.3 feet below the crown. Slidegate on LS toe and a Flap gate on the waterward end. Brass cap No. 90 BM on headwall on the landward side. (USACE-1967). This entry matches the Drainage or Irrigation Structure referenced in O&M manual (HLM 6.90). FS Date: 04/08/2014

Pipe, concrete headwall, and slidegate on LS toe. Debris blocking closure of slidegate.

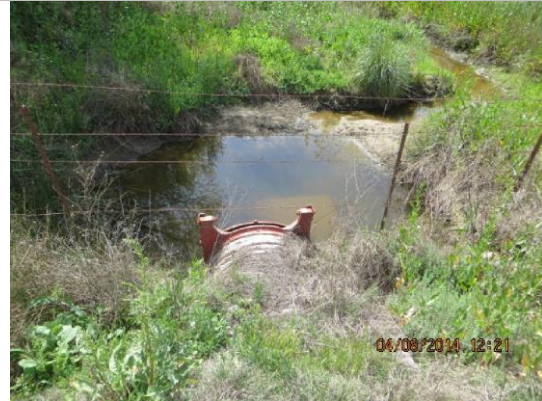
Photo 2 of 2 : UCIP_FA_2015_4541.jpg

LM Start	6.86	Rating **	U	Issue No.	1207 (cont)
LM End	6.86	Issue Type +	En	Location *	LS
Category	Supplemental			GPS Latitude/Longitude	
				Start	End
Item	DWR UCIP Field Study			37.302098 °	37.302098
				-120.887943 °	-120.887943
DWR ID					
Action/Comments					
Inspector Comments: FS_ID:42850 DS_ID:19615 EP_NO: N/A FS_HLM: 6.897 Repair Type: Urgent Crossing Status: Found UCIP Comments: Slide gate blocked by debris at LS toe. Flapgate won't close because of debris. Dense vegetation limits the inspector's visibility to identify signs of pipe failure (leaks) along the slope. Recommend removing vegetation along pipe alignment to conduct proper inspection of structure and appurtenances. FIELD_STRUCT_DESC: 36-inch CM stormdrain pipe through the levee, 10.3 feet below the crown. Slidegate on LS toe and a Flap gate on the waterward end. Brass cap No. 90 BM on headwall on the landward side. (USACE-1967). This entry matches the Drainage or Irrigation Structure referenced in O&M manual (HLM 6.90). FS Date: 04/08/2014

Pipe, headwall, and flapgate on WS toe.

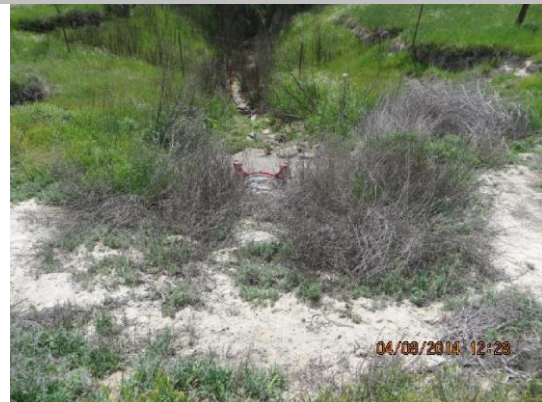
Photo 1 of 3 : UCIP_FA_2015_4542.jpg

LM Start	7.18	Rating **	M	Issue No.	1208
LM End	7.18	Issue Type +	En	Location *	LS
Category	Supplemental			GPS Latitude/Longitude	
				Start	End
Item	DWR UCIP Field Study			37.300055 °	37.300055 °
				-120.882939 °	-120.882939 °
DWR ID					
Action/Comments					
Inspector Comments: FS_ID:42851 DS_ID:19616 EP_NO: N/A FS_HLM: 7.213 Repair Type: Non-Urgent Crossing Status: Found UCIP Comments: Pipe failing and corroded through at LS toe. Need to contact owner to determine status of crossing. Also dense vegetation limits the inspector's visibility to identify signs of pipe failure (leaks) along the landward slope. Recommend removing vegetation along pipe alignment to conduct proper inspection of structure. FIELD_STRUCT_DESC: 24-inch CM stormdrain pipe through the levee, 5.1 feet below the crown. Flap gate on the waterward end. Brass cap No. 90 BM on headwall on the landward side. (USACE-1967). This entry matches the Drainage or Irrigation Structure referenced in O&M manual (HLM 7.21). FS Date: 04/08/2014

Pipe, concrete headwall, and flapgate on WS toe.

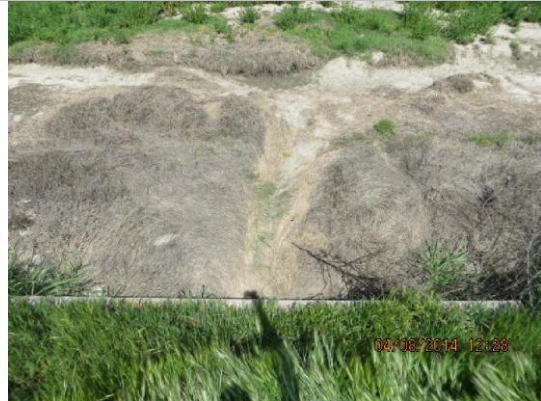
Photo 2 of 3 : UCIP_FA_2015_4543.jpg

LM Start	7.18	Rating **	M	Issue No.	1208 (cont)
LM End	7.18	Issue Type +	En	Location *	LS
Category	Supplemental			GPS Latitude/Longitude	
				Start	End
Item	DWR UCIP Field Study			37.300055 °	37.300055 °
				-120.882939 °	-120.882939 °
DWR ID					
Action/Comments					
Inspector Comments: FS_ID:42851 DS_ID:19616 EP_NO: N/A FS_HLM: 7.213 Repair Type: Non-Urgent Crossing Status: Found UCIP Comments: Pipe failing and corroded through at LS toe. Need to contact owner to determine status of crossing. Also dense vegetation limits the inspector's visibility to identify signs of pipe failure (leaks) along the landward slope. Recommend removing vegetation along pipe alignment to conduct proper inspection of structure. FIELD_STRUCT_DESC: 24-inch CM stormdrain pipe through the levee, 5.1 feet below the crown. Flap gate on the waterward end. Brass cap No. 90 BM on headwall on the landward side. (USACE-1967). This entry matches the Drainage or Irrigation Structure referenced in O&M manual (HLM 7.21). FS Date: 04/08/2014

Pipe and Concrete headwall visible on LS toe.
