**Flood Control Project Maintenance
Levee Inspections**

Fall 2015 Levee Maintenance Deficiency Summary Report

San Joaquin River Basin

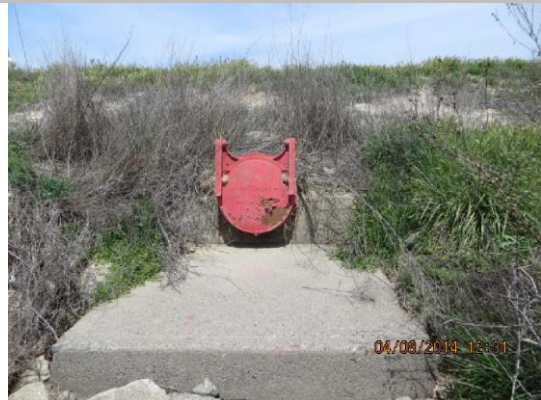
Photo 3 of 3 : UCIP_FA_2015_4544.jpg

LM Start	7.18	Rating **	M	Issue No.	1208 (cont)
LM End	7.18	Issue Type +	En	Location *	LS
Category	Supplemental			GPS Latitude/Longitude	
				Start	End
Item	DWR UCIP Field Study			37.300055 °	37.300055 °
				-120.882939 °	-120.882939 °
DWR ID					
Action/Comments					
Inspector Comments: FS_ID:42851 DS_ID:19616 EP_NO: N/A FS_HLM: 7.213 Repair Type: Non-Urgent Crossing Status: Found UCIP Comments: Pipe failing and corroded through at LS toe. Need to contact owner to determine status of crossing. Also dense vegetation limits the inspector's visibility to identify signs of pipe failure (leaks) along the landward slope. Recommend removing vegetation along pipe alignment to conduct proper inspection of structure. FIELD_STRUCT_DESC: 24-inch CM stormdrain pipe through the levee, 5.1 feet below the crown. Flap gate on the waterward end. Brass cap No. 90 BM on headwall on the landward side. (USACE-1967). This entry matches the Drainage or Irrigation Structure referenced in O&M manual (HLM 7.21). FS Date: 04/08/2014

Flapgate and concrete headwall on WS toe.

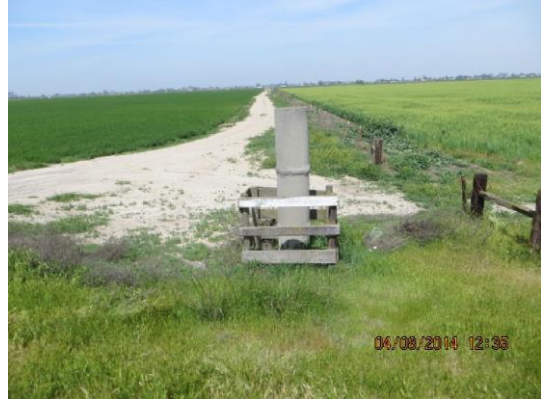
Photo 1 of 3 : UCIP_FA_2015_4545.jpg

LM Start	7.29	Rating **	M	Issue No.	1209
LM End	7.29	Issue Type +	En	Location *	LS
Category	Supplemental			GPS Latitude/Longitude	
				Start	End
Item	DWR UCIP Field Study			37.299931 °	37.299931 °
				-120.880947 °	-120.880947 °
DWR ID					
Action/Comments					
Inspector Comments: FS_ID:39160					
DS_ID:19617					
EP_NO: 4425					
FS_HLM: 7.324					
Repair Type: Non-Urgent					
Crossing Status: Found

20-inch concrete standpipe off LS toe.

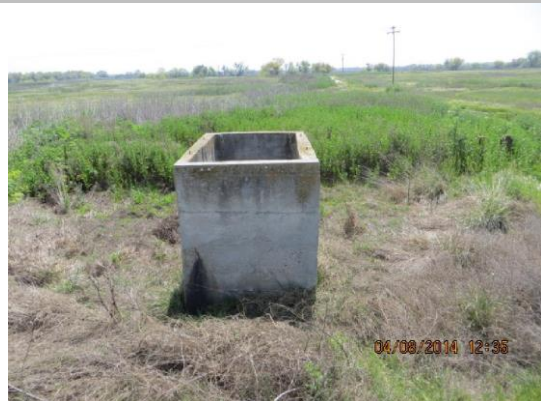
Photo 2 of 3 : UCIP_FA_2015_4546.jpg

5'X7' concrete box riser on WS toe.

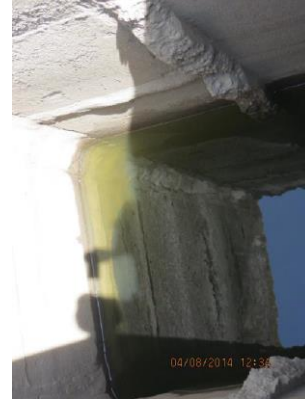
Photo 3 of 3 : UCIP_FA_2015_4547.jpg

LM Start	7.29	Rating **	M	Issue No.	1209 (cont)
LM End	7.29	Issue Type +	En	Location *	LS
Category	Supplemental			GPS Latitude/Longitude	
				Start	End
Item	DWR UCIP Field Study			37.299931 °	37.299931 °
				-120.880947 °	-120.880947 °
DWR ID					
Action/Comments					
Inspector Comments: FS_ID:39160					
DS_ID:19617					
EP_NO: 4425					
FS_HLM: 7.324					
Repair Type: Non-Urgent					
Crossing Status: Found

Pipe visible under water in concrete box riser on WS toe.

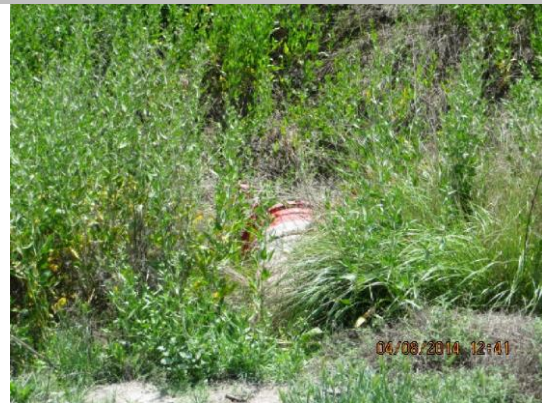
Photo 1 of 3 : UCIP_FA_2015_4548.jpg

Pipe and flapgate visible on WS toe.

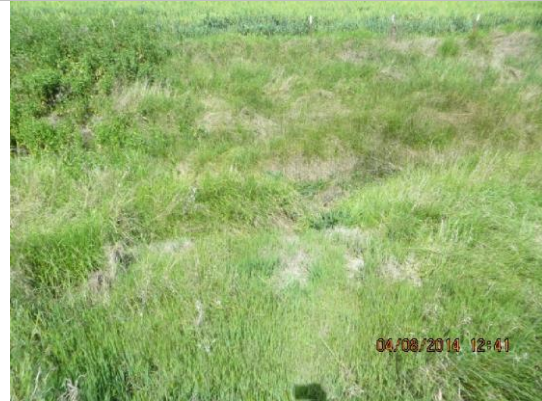
Photo 2 of 3 : UCIP_FA_2015_4549.jpg

Concrete headwall and pipe visible off LS toe in heavy vegetation.

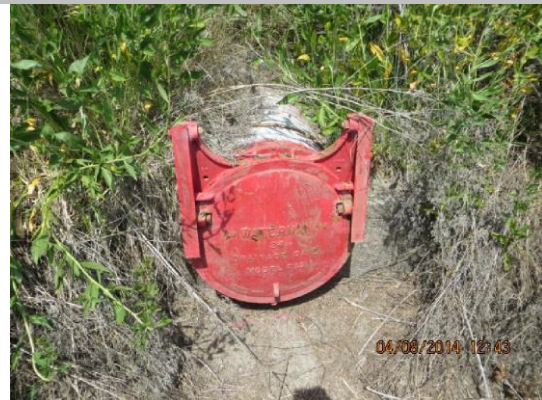
Photo 3 of 3 : UCIP_FA_2015_4550.jpg

Pipe and flapgate visible on WS toe.

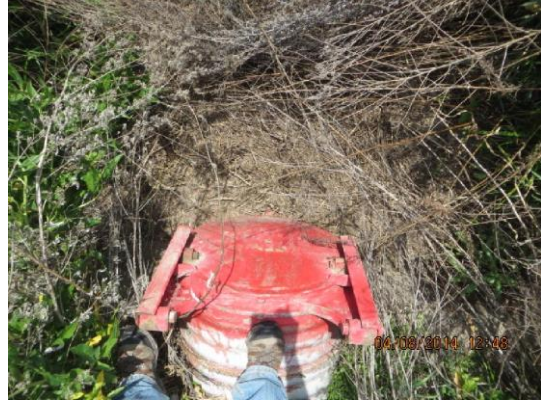
Photo 1 of 3 : UCIP_FA_2015_4551.jpg

Flapgate and headwall at WS toe.

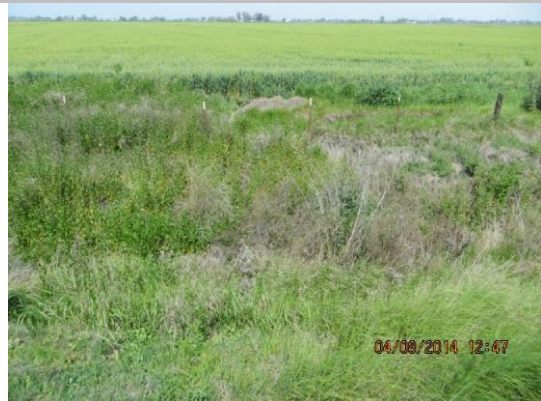
Photo 2 of 3 : UCIP_FA_2015_4552.jpg

Concrete headwall at LS toe. Heavy vegetation on both slopes.

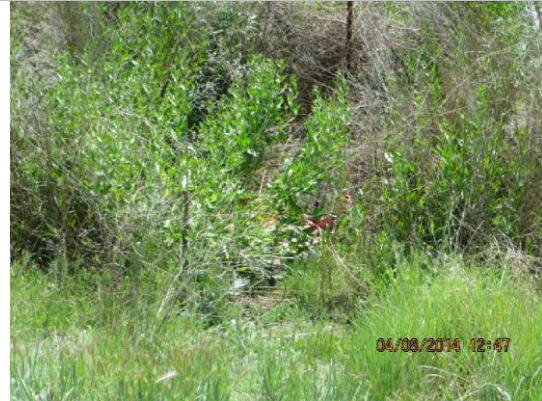
Photo 3 of 3 : UCIP_FA_2015_4553.jpg

Flapgate and headwall at WS toe. Heavy vegetation on slopes.

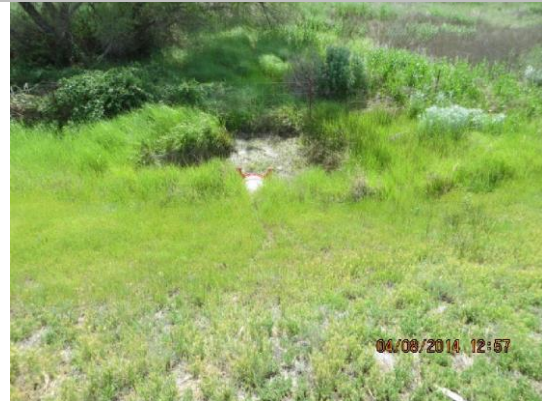
Photo 1 of 3 : UCIP_FA_2015_4554.jpg

Pipe, Headwall, and flapgate at WS toe.

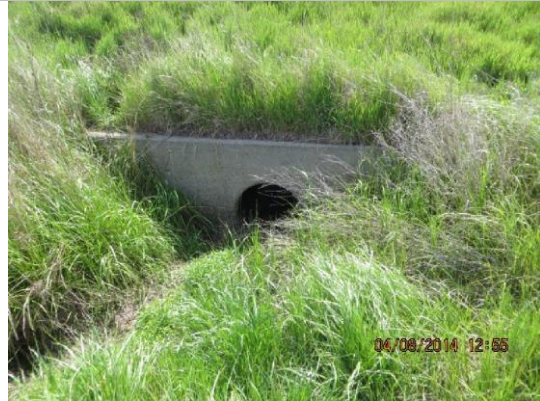
Photo 2 of 3 : UCIP_FA_2015_4555.jpg

Pipe and concrete headwall on LS toe.

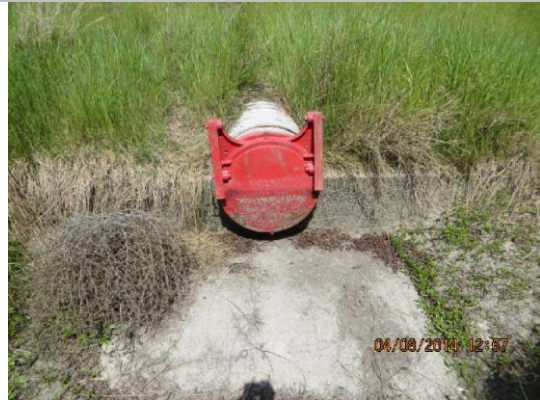
Photo 3 of 3 : UCIP_FA_2015_4556.jpg

Pipe, Headwall, and flapgate at WS toe.

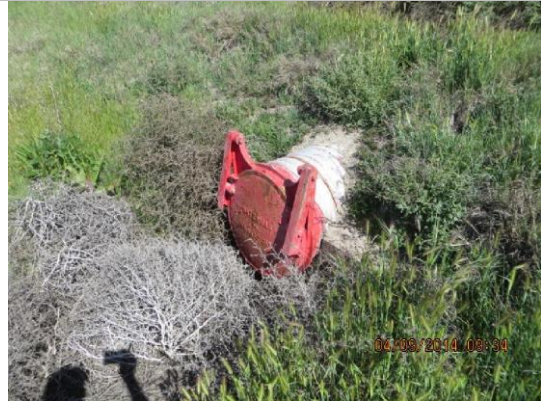
Photo 1 of 3 : UCIP_FA_2015_4557.jpg

Concrete headwall, pipe, and flapgate at WS toe.

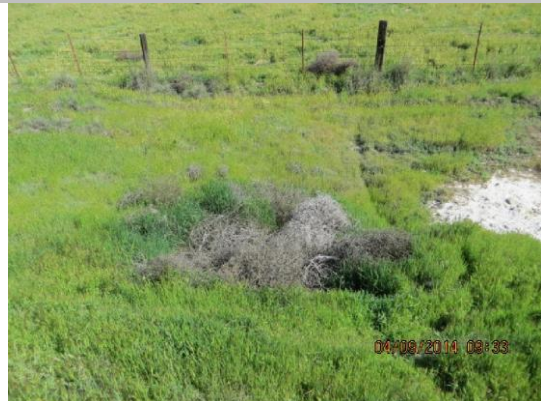
Photo 2 of 3 : UCIP_FA_2015_4558.jpg

Pipe and concrete headwall at LS toe. Note heavy vegetation.

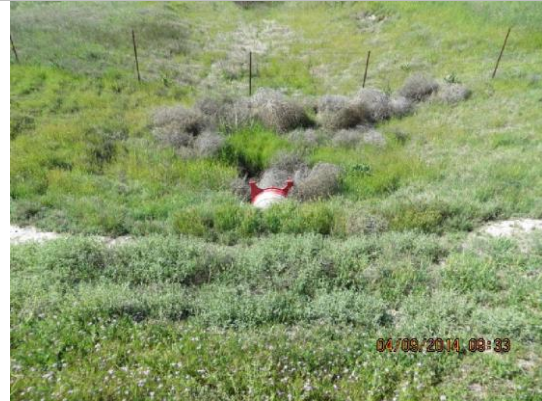
Photo 3 of 3 : UCIP_FA_2015_4559.jpg

Concrete headwall, pipe, and flapgate at WS toe.

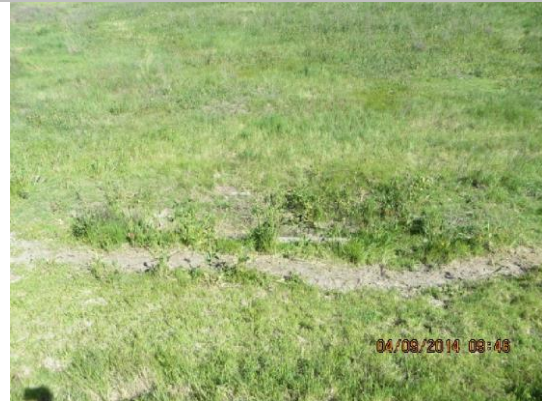
Photo 1 of 3 : UCIP_FA_2015_4641.jpg

Pipe and headwall visible on LS toe.

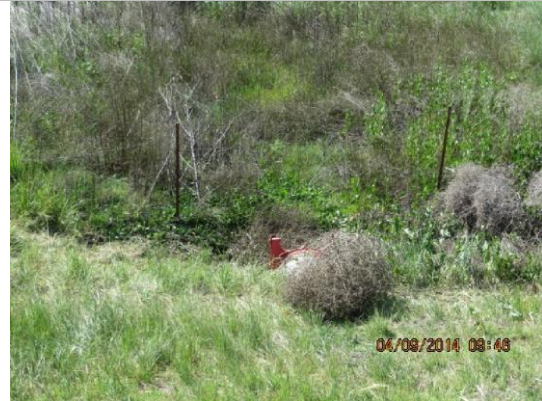
Photo 2 of 3 : UCIP_FA_2015_4642.jpg

Pipe, flapgate, and headwall on WS toe.

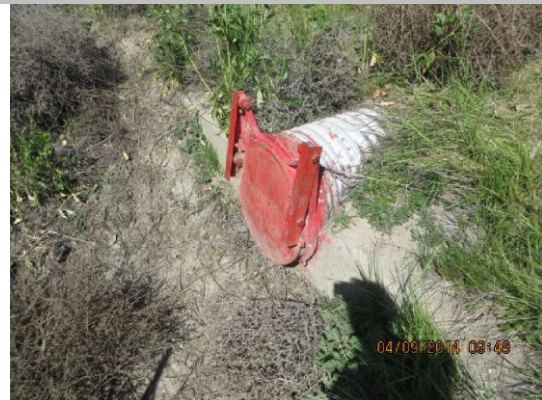
Photo 3 of 3 : UCIP_FA_2015_4678.jpg

Pipe, flapgate, and headwall on WS toe.

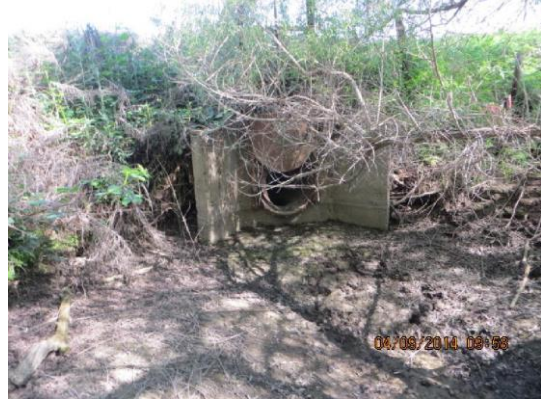
Photo 1 of 3 : UCIP_FA_2015_4679.jpg

Slidegate and headwall at WS toe.

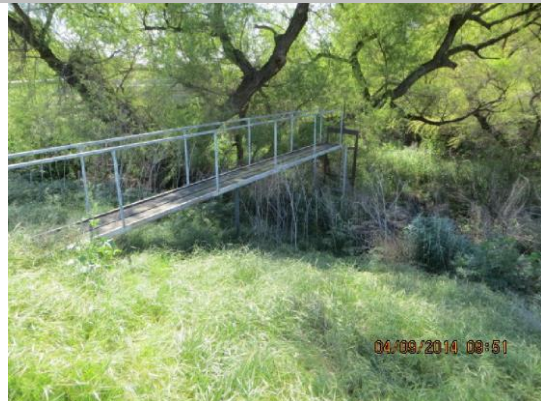
Photo 2 of 3 : UCIP_FA_2015_4680.jpg

Metal walkway to slidegate operator on WS toe.

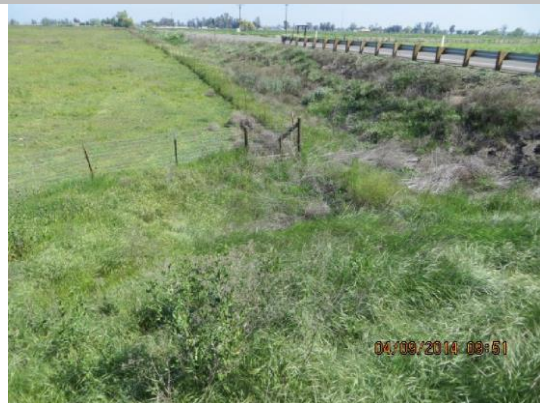
Photo 1 of 3 : UCIP_FA_2015_4682.jpg

Pipe and headwall visible on LS toe.

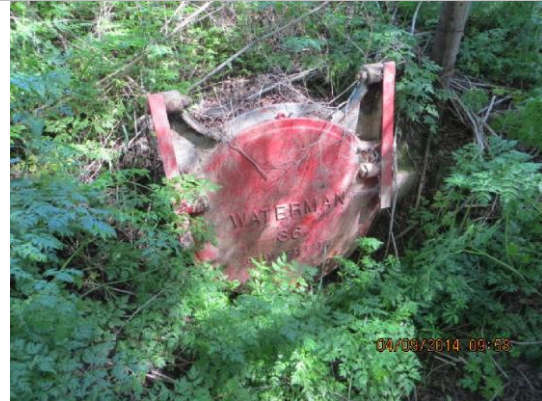
Photo 2 of 3 : UCIP_FA_2015_4683.jpg

Pipe and flapgate visible on WS toe.

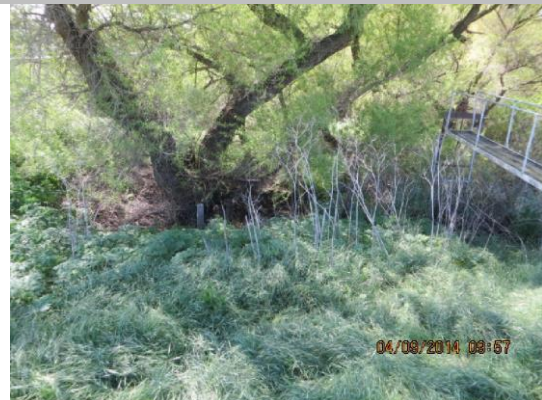
Photo 3 of 3 : UCIP_FA_2015_4684.jpg

Pipe and flapgate visible on WS toe.

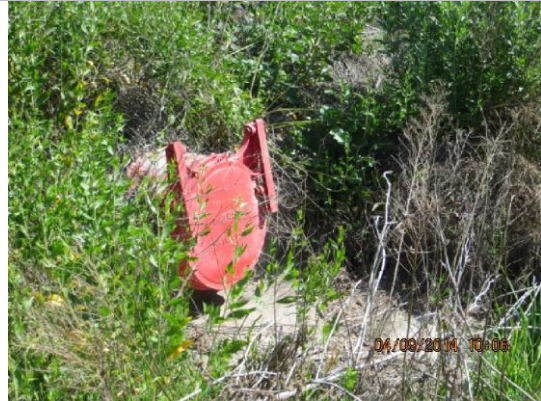
Photo 1 of 2 : UCIP_FA_2015_4685.jpg

Pipe, concrete headwall, and flapgate at WS toe.

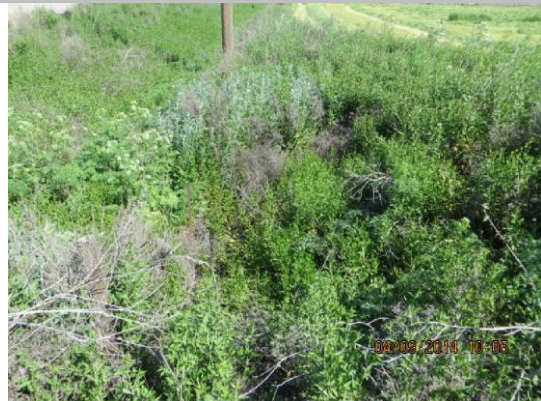
Photo 2 of 2 : UCIP_FA_2015_4686.jpg

Heavy vegetation on LS toe.

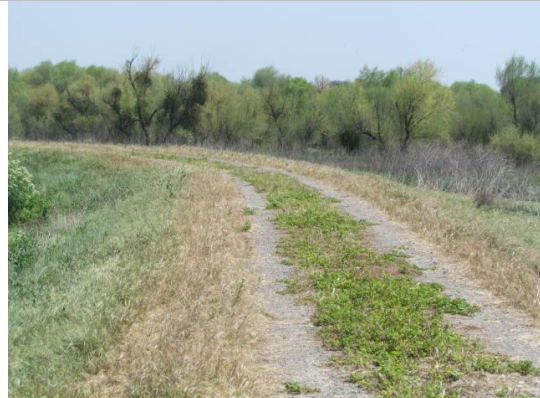
Photo 1 of 3 : FA_2015_NA0010_118_117_20150914_00025.jpg

LM Start	9.16	Rating **	A/W	Issue No.	117
LM End	9.78	Issue Type +	Ma	Location *	CR
Category	Earthen Levee			GPS Latitude/Longitude	
				Start	End
Item	Crown Surface / Depressions / Rutting			37.296145 °	37.293077 °
				-120.848588 °	-120.839170 °
DWR ID	DWR_NA0010_01_s_2012_117				
Action/Comments					
Add appropriate material and re-grade the levee to bring the crown above the design elevation.					
Inspector Comments: Control vegetation on levee crown.

Looking south at typical view of vegetation on levee crown.

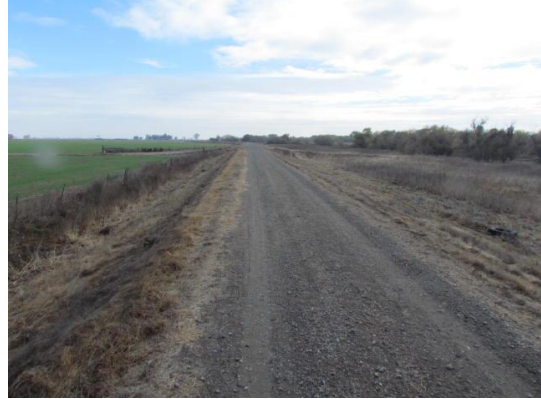
Photo 2 of 3 : FA_2015_NA0010_118_117_20150914_00026.jpg

Looking south at levee crown. (Fall 2013)

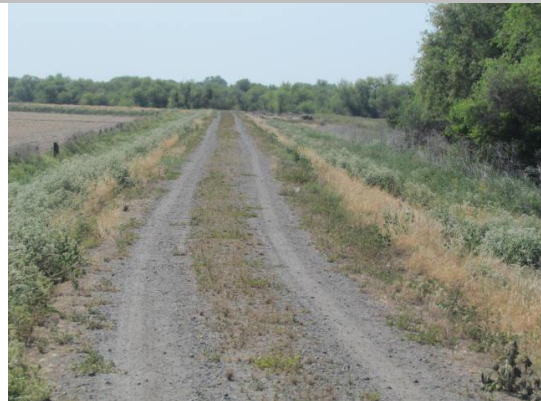
Photo 3 of 3 : FA_2015_NA0010_118_117_20150914_00027.jpg

Looking south at vegetation on levee crown. (Spring 2013)

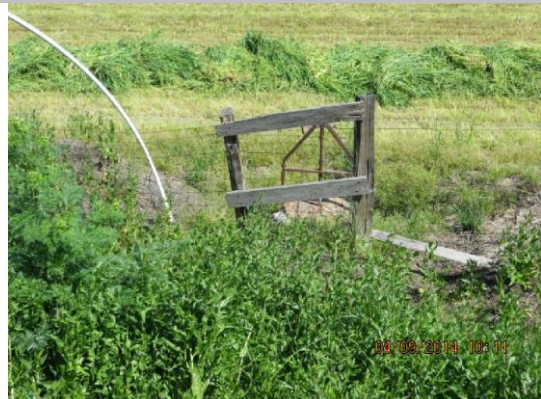
Photo 1 of 3 : UCIP_FA_2015_4687.jpg

Concrete drop-inlet installed on pipe at LS toe.

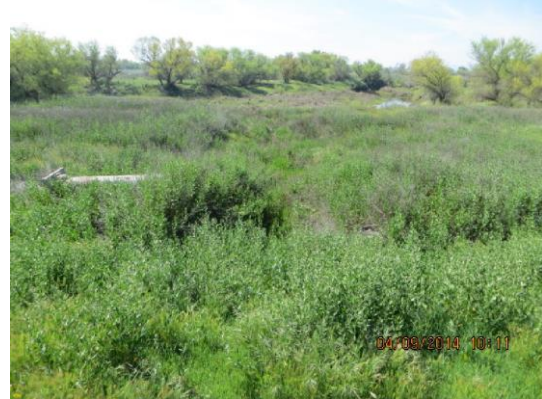
Photo 2 of 3 : UCIP_FA_2015_4688.jpg

Pipe and flapgate on WS toe.

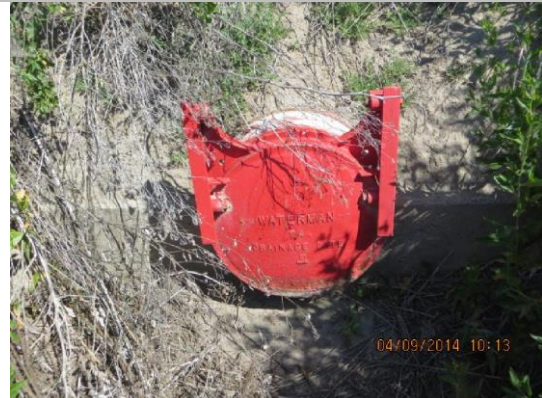
Photo 3 of 3 : UCIP_FA_2015_4689.jpg

Headwall, Pipe, and flapgate on WS toe.

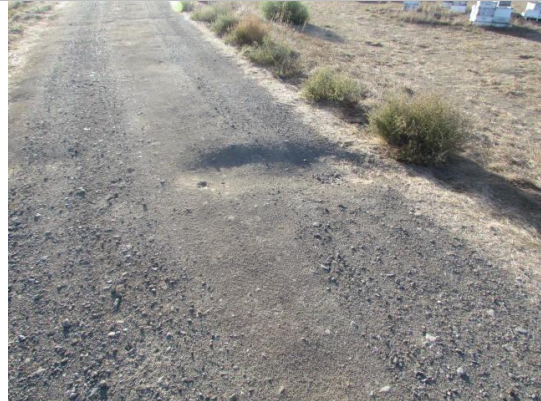
Photo 1 of 3 : FA_2015_NA0010_118_14_20151012_00035.jpg

LM Start	9.57	Rating **	M	Issue No.	14
LM End	9.57	Issue Type +	Ma	Location *	CR
Category	Earthen Levee			GPS Latitude/Longitude	
				Start	End
Item	Crown Surface / Depressions / Rutting			37.295517 °	37.295517 °
				-120.841452 °	-120.841452 °
DWR ID	DWR_NA0010_01_s_2015_14				
Action/Comments					
Repair depressions or ruts in the crown or slope. Inspector Comments: Depression greater than 3" deep by 18" wide by 18" long on levee crown

Looking at depression on levee crown. (Fall 2015)

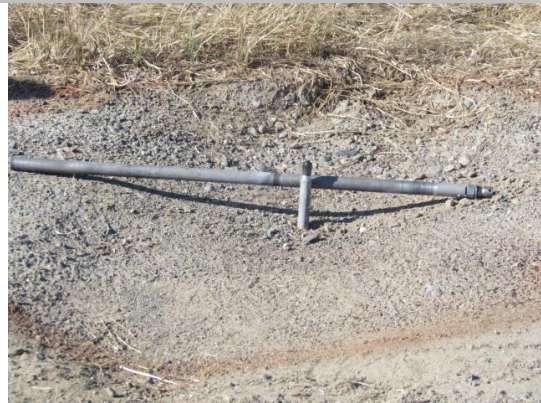
Photo 2 of 3 : FA_2015_NA0010_118_14_20150914_00011.jpg

Looking west at depression greater than three inches on levee crown.

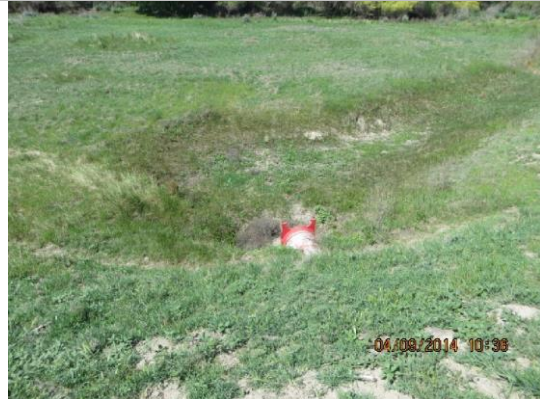
Photo 1 of 3 : UCIP_FA_2015_4690.jpg

Pipe, headwall, and flapgate on WS toe.

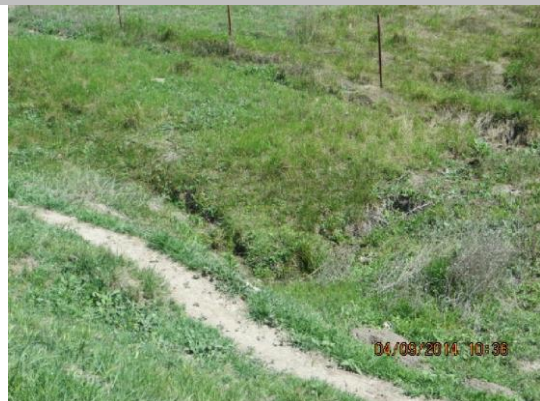
Photo 2 of 3 : UCIP_FA_2015_4691.jpg

Pipe and headwall at LS toe.

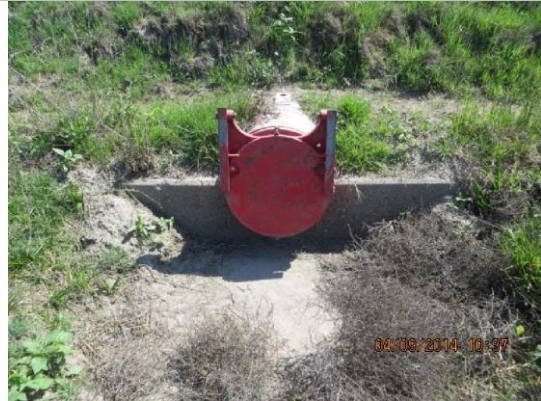
Photo 3 of 3 : UCIP_FA_2015_4692.jpg

Pipe, headwall, and flapgate at WS toe.

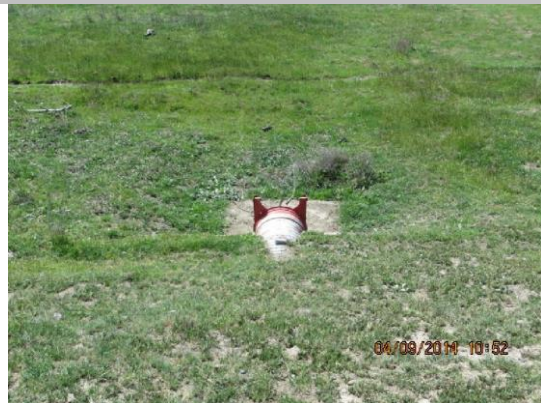
Photo 1 of 3 : UCIP_FA_2015_4693.jpg

Pipe, headwall, and flapgate on WS toe.

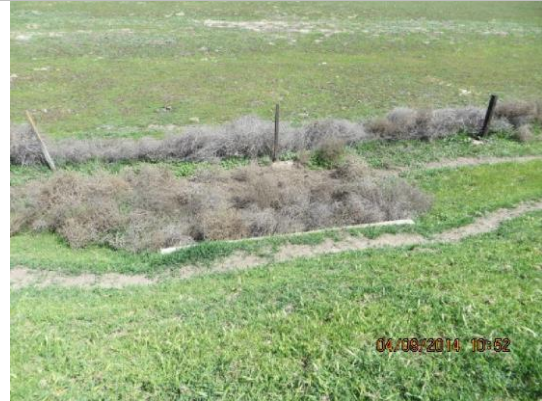
Photo 2 of 3 : UCIP_FA_2015_4694.jpg

Inspector Comments: FS_ID:39255
 DS_ID:19632
 EP_NO: N/A
 FS_HLM: 11.028
 Repair Type: Non-Urgent
 Crossing Status: Found
 UCIP Comments: Dense vegetation blocks landward headwall.
 Recommend removing excess vegetation on landward toe.
 FIELD_STRUCT_DESC: 24-inch CM stormdrain pipe through the levee, 6.0 feet below the crown. Flap gate on the waterward end. Brass cap No. 66 BM on headwall on the landward side. (USACE-1967). This entry matches the Drainage or Irrigation Structure referenced in O&M manual (HLM 11.00).
 FS Date: 04/09/2014

Pipe and headwall on LS toe.

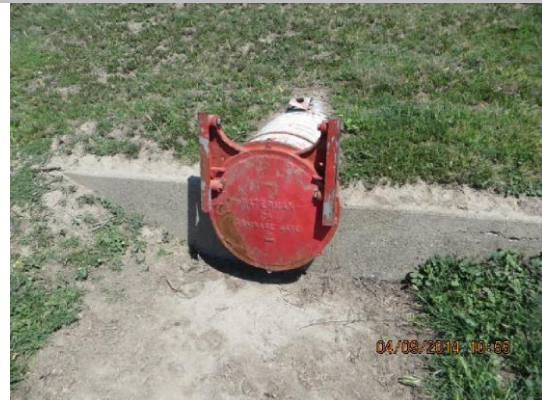
Photo 3 of 3 : UCIP_FA_2015_4695.jpg

Pipe, headwall, and flapgate on WS toe.

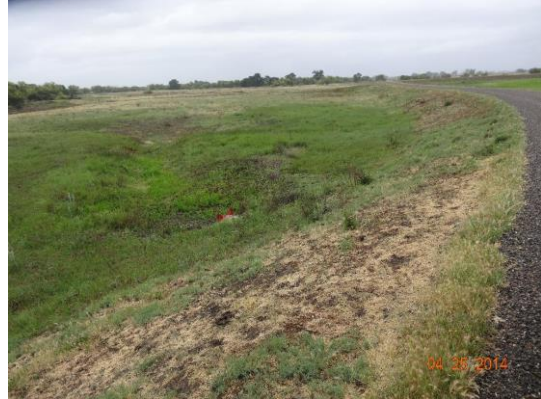
Photo 1 of 3 : UCIP_FA_2015_5380.jpg

View of waterward side.

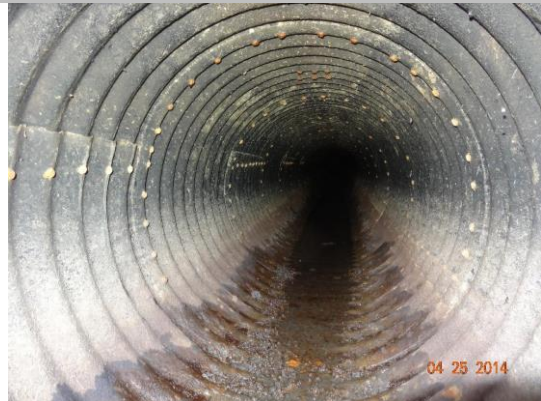
Photo 2 of 3 : UCIP_FA_2015_5381.jpg

Inside view of pipe from waterward side.

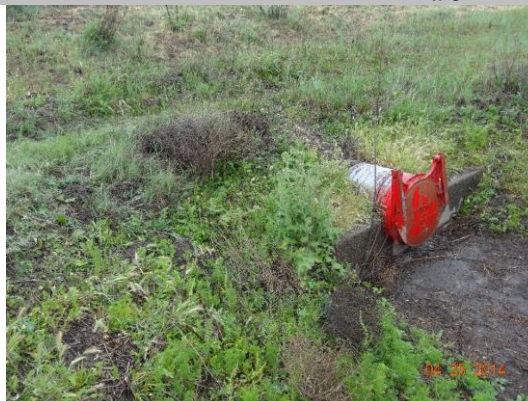
Photo 3 of 3 : UCIP_FA_2015_5382.jpg

View of concrete headwall and flap gate visible on waterward side.

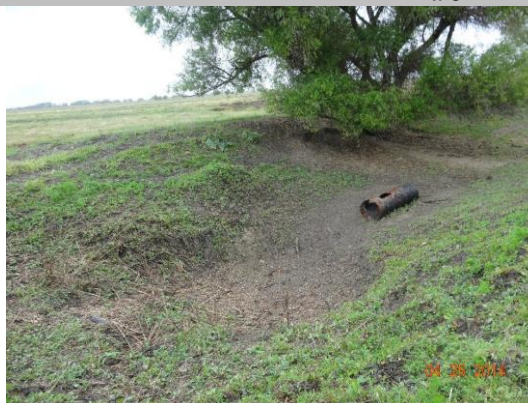
Photo 1 of 3 : UCIP_FA_2015_5383.jpg

Landward side of crossing buried--damage pipe section visible on landward side.

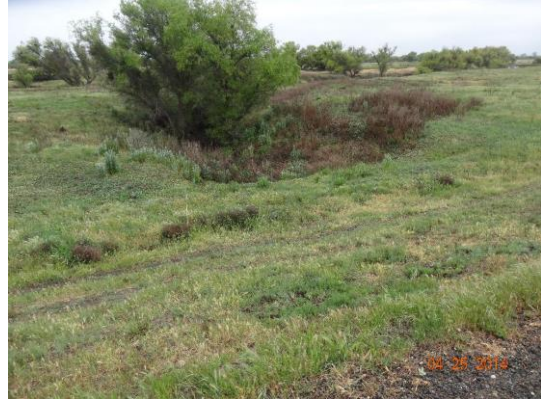
Photo 2 of 3 : UCIP_FA_2015_5384.jpg

View of waterward side.

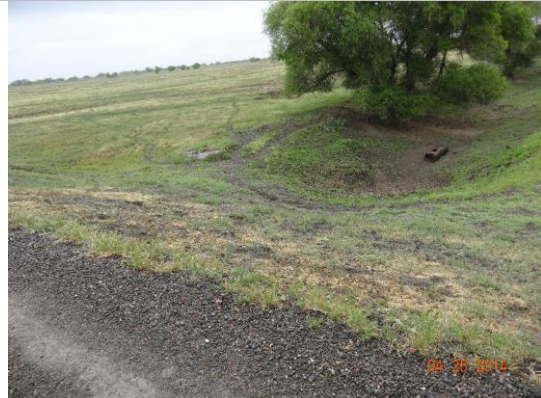
Photo 3 of 3 : UCIP_FA_2015_5385.jpg

View of landward side.

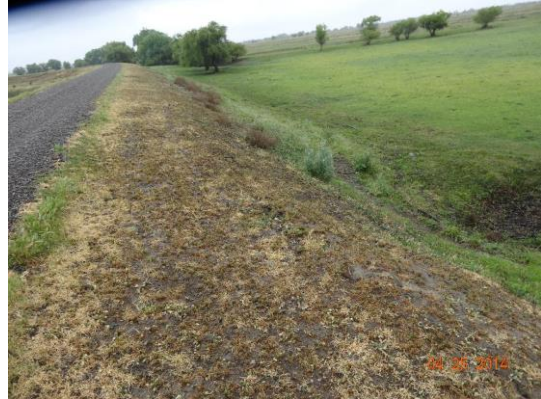
Photo 1 of 3 : UCIP_FA_2015_5386.jpg

View of landward side.

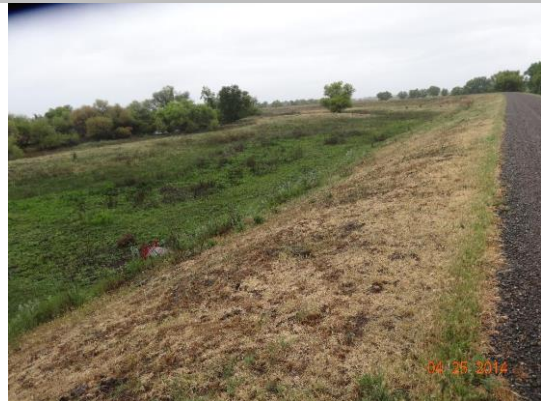
Photo 2 of 3 : UCIP_FA_2015_5387.jpg

View of waterward side--flap gate visible on waterward toe.

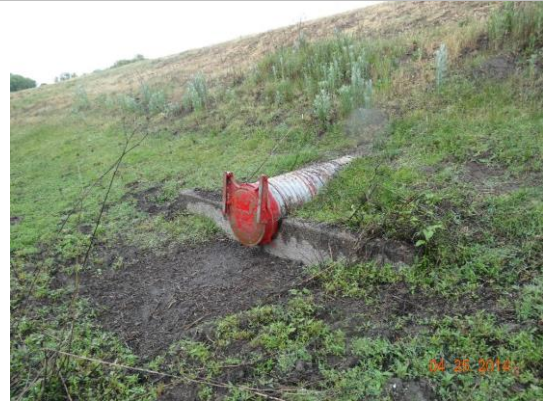
Photo 3 of 3 : UCIP_FA_2015_5388.jpg

Flap gate and concrete headwall visible on waterward side.

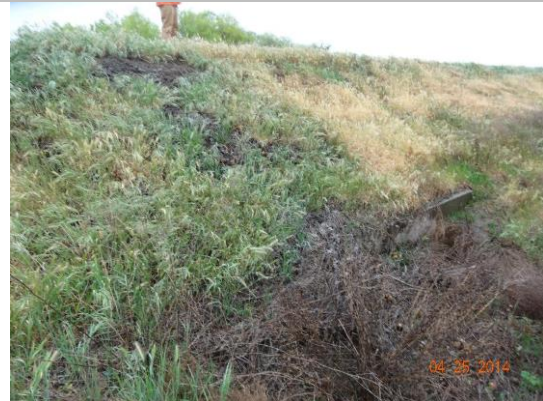
Photo 1 of 3 : UCIP_FA_2015_4867.jpg

View of landward side--concrete headwall visible covered by dense vegetation.

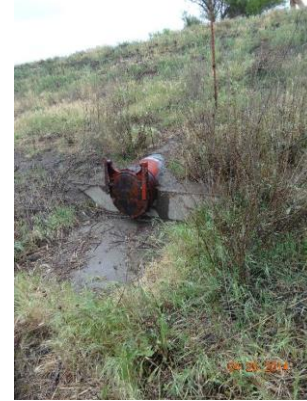
Photo 2 of 3 : UCIP_FA_2015_4868.jpg

Flap gate and concrete headwall visible on waterward side.

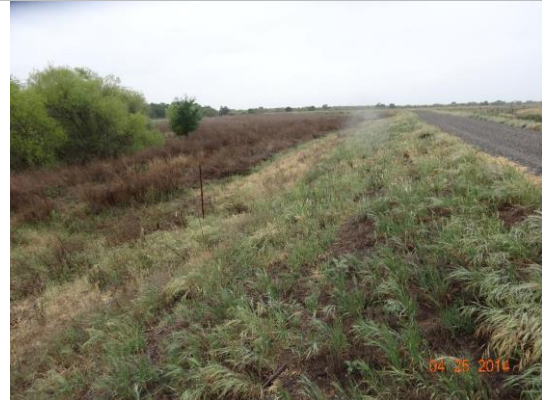
Photo 3 of 3 : UCIP_FA_2015_4869.jpg

View of waterward side.

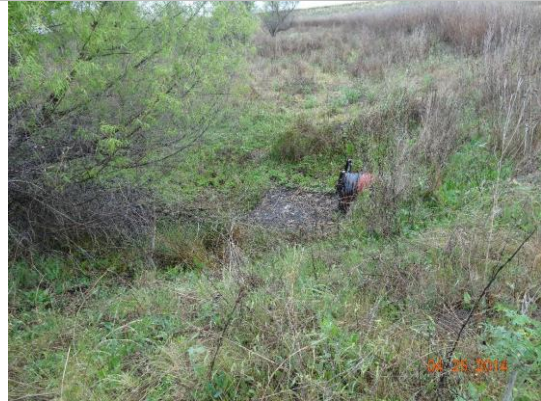
Photo 1 of 3 : UCIP_FA_2015_5438.jpg

View of flap gate and pipe through levee on waterward side.

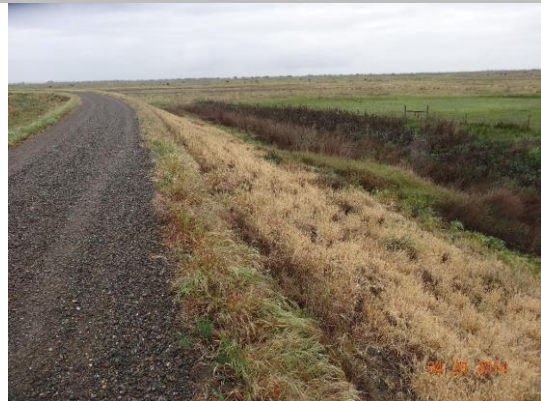
Photo 2 of 3 : UCIP_FA_2015_5439.jpg

View of landward side.

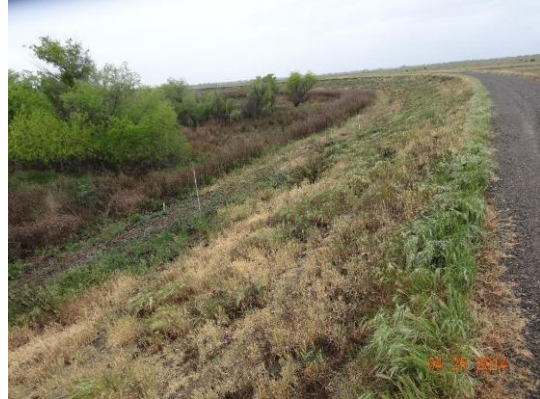
Photo 3 of 3 : UCIP_FA_2015_5440.jpg

View of waterward side.

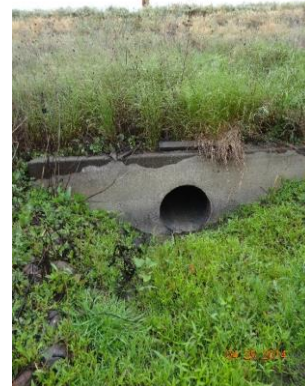
Photo 1 of 3 : UCIP_FA_2015_4870.jpg

Concrete headwall visible from landward side.

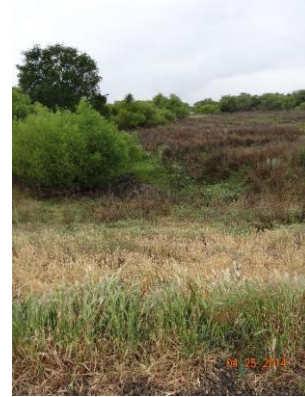
Photo 2 of 3 : UCIP_FA_2015_4871.jpg

Dense vegetation on waterward side.

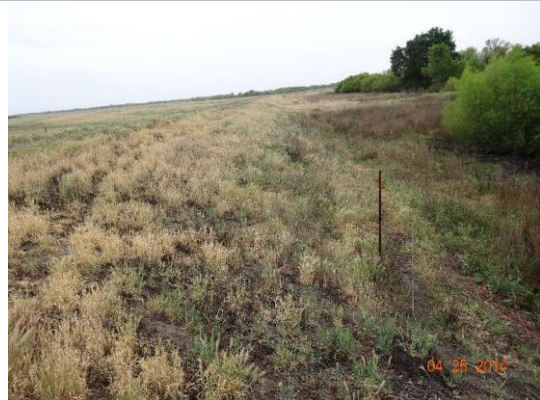
Photo 3 of 3 : UCIP_FA_2015_4872.jpg

View of waterward side.

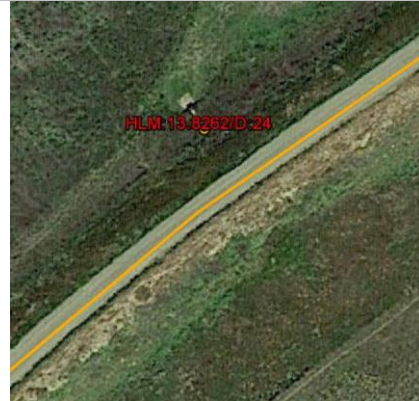
Photo 1 of 1 : UCIP_FA_2015_4801.jpg

Indicators of crossing visible from aerial photograph.

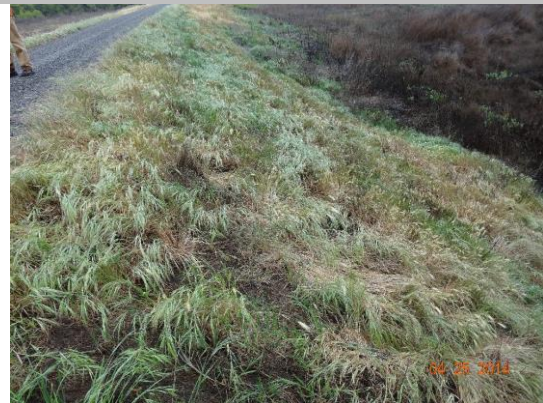
Photo 1 of 3 : UCIP_FA_2015_4873.jpg

View of landward side.

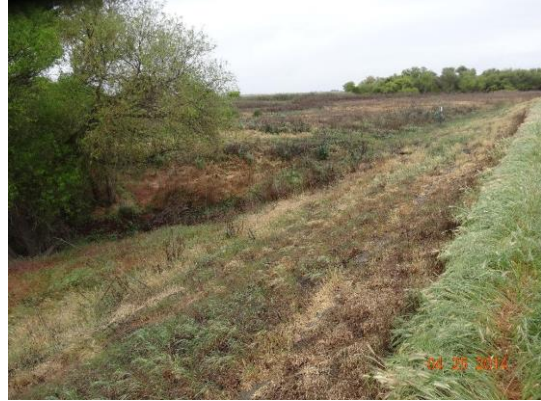
Photo 2 of 3 : UCIP_FA_2015_4874.jpg

LM Start	14.22	Rating **	M	Issue No.	1228 (cont)
LM End	14.22	Issue Type +	En	Location *	CR
Category	Supplemental			GPS Latitude/Longitude	
				Start	End
Item	DWR UCIP Field Study			37.242225 °	37.242225 °
				-120.817665 °	-120.817665 °
DWR ID					
Action/Comments					
Inspector Comments: FS_ID:36166 DS_ID:19641 EP_NO: N/A FS_HLM: 14.22 Repair Type: Non-Urgent Crossing Status: Found UCIP Comments: Dense vegetation limits the inspector's visibility to identify signs of pipe failure (leaks) along the slopes. Recommend removing vegetation along pipe alignment to conduct proper inspection of structure. FIELD_STRUCT_DESC: 24-inch CM pipe through the levee, 13.0 feet below the crown. Flap gate on the waterward end. Brass cap No. 60 BM on headwall on the landward side. (USACE-1967). This entry matches the Drainage or Irrigation Structure referenced in O&M manual (HLM 14.21). FS Date: 04/25/2014

View of waterward side.

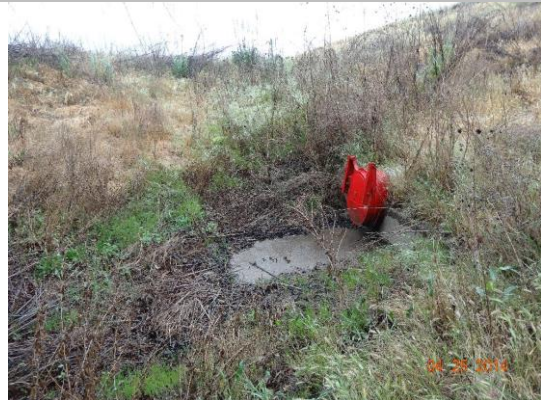
Photo 3 of 3 : UCIP_FA_2015_4978.jpg

View of concrete headwall, concrete apron, and flap gate on waterward side.

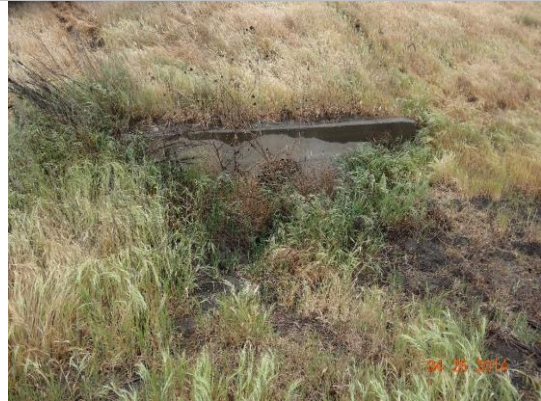
Photo 1 of 3 : UCIP_FA_2015_4979.jpg

LM Start	14.65	Rating **	M	Issue No.	1229
LM End	14.65	Issue Type +	En	Location *	CR
Category	Supplemental			GPS Latitude/Longitude	
				Start	End
Item	DWR UCIP Field Study			37.237584 °	37.237584 °
				-120.812967 °	-120.812967 °
DWR ID					
Action/Comments					
Inspector Comments: FS_ID:36167 DS_ID:19642 EP_NO: N/A FS_HLM: 14.66 Repair Type: Non-Urgent Crossing Status: Found

Concrete headwall located on landward toe.

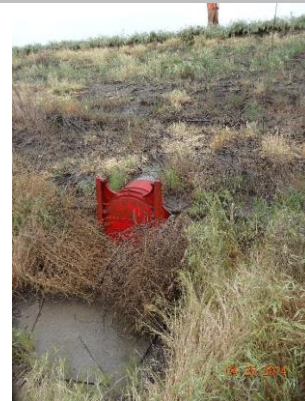
Photo 2 of 3 : UCIP_FA_2015_4980.jpg

Flap gate, concrete headwall, and concrete apron located on waterward toe.

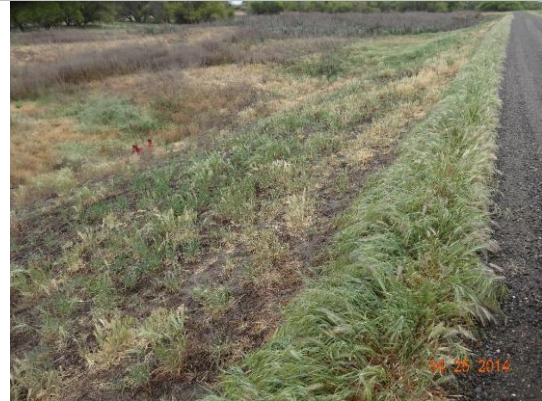
Photo 3 of 3 : UCIP_FA_2015_4981.jpg

LM Start	14.65	Rating **	M	Issue No.	1229 (cont)
LM End	14.65	Issue Type +	En	Location *	CR
Category	Supplemental			GPS Latitude/Longitude	
				Start	End
Item	DWR UCIP Field Study			37.237584 °	37.237584 °
				-120.812967 °	-120.812967 °
DWR ID					
Action/Comments					
Inspector Comments: FS_ID:36167 DS_ID:19642 EP_NO: N/A FS_HLM: 14.66 Repair Type: Non-Urgent Crossing Status: Found

View of waterward side.

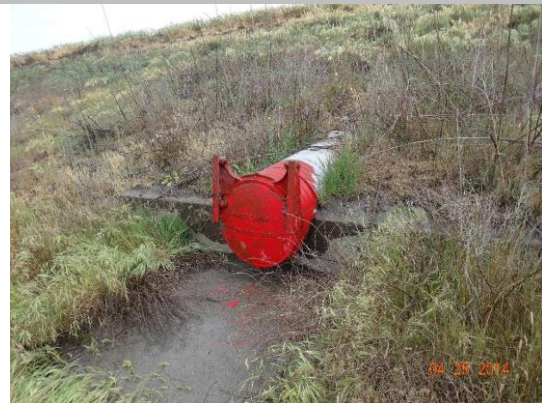
Photo 1 of 3 : UCIP_FA_2015_4982.jpg

LM Start	15.29	Rating **	M	Issue No.	1230
LM End	15.29	Issue Type +	En	Location *	CR
Category	Supplemental			GPS Latitude/Longitude	
				Start	End
Item	DWR UCIP Field Study			37.231428 °	37.231428 °
				-120.805543 °	-120.805543 °
DWR ID					
Action/Comments					
Inspector Comments: FS_ID:36168 DS_ID:19643 EP_NO: N/A FS_HLM: 15.3 Repair Type: Non-Urgent Crossing Status: Found UCIP Comments: Dense vegetation limits the inspector's visibility to identify signs of pipe failure (leaks) along the landward slope. Recommend removing vegetation along pipe alignment to conduct proper inspection of structure. FIELD_STRUCT_DESC: 24-inch CM pipe through the levee, 9.2 feet below the crown. Flap gate on the waterward end. Brass cap No. 60 BM on headwall on the landward side. (USACE-1967). This entry matches the Drainage or Irrigation Structure referenced in O&M manual (HLM 15.29). FS Date: 04/25/2014

Concrete headwall, flap gate, and concrete apron located on waterward side.

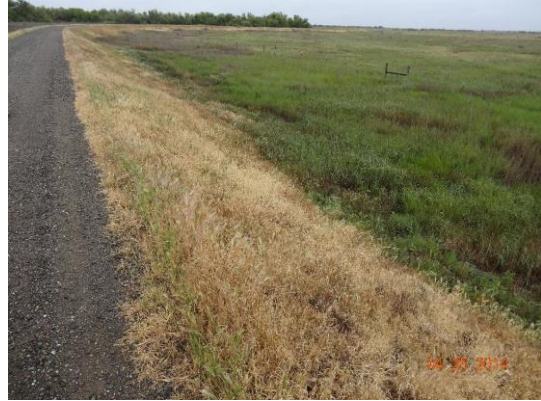
Photo 2 of 3 : UCIP_FA_2015_4983.jpg

LM Start	15.29	Rating **	M	Issue No.	1230 (cont)
LM End	15.29	Issue Type +	En	Location *	CR
Category	Supplemental			GPS Latitude/Longitude	
				Start	End
Item	DWR UCIP Field Study			37.231428 °	37.231428 °
				-120.805543 °	-120.805543 °
DWR ID					
Action/Comments					
Inspector Comments: FS_ID:36168 DS_ID:19643 EP_NO: N/A FS_HLM: 15.3 Repair Type: Non-Urgent Crossing Status: Found UCIP Comments: Dense vegetation limits the inspector's visibility to identify signs of pipe failure (leaks) along the landward slope. Recommend removing vegetation along pipe alignment to conduct proper inspection of structure. FIELD_STRUCT_DESC: 24-inch CM pipe through the levee, 9.2 feet below the crown. Flap gate on the waterward end. Brass cap No. 60 BM on headwall on the landward side. (USACE-1967). This entry matches the Drainage or Irrigation Structure referenced in O&M manual (HLM 15.29). FS Date: 04/25/2014

View of landward side.

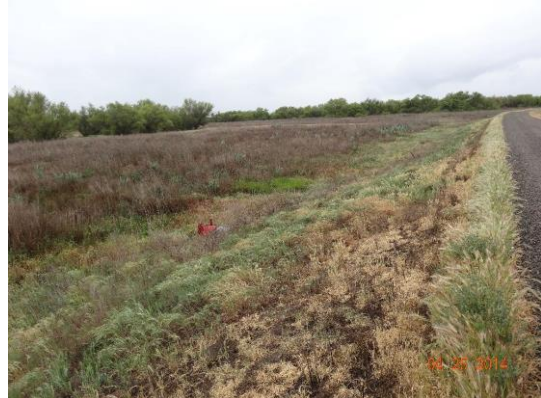
Photo 3 of 3 : UCIP_FA_2015_4984.jpg

View of waterward side.

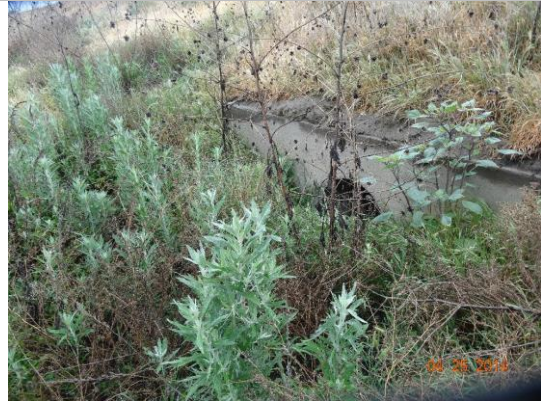
Photo 1 of 3 : UCIP_FA_2015_4985.jpg

LM Start	15.58	Rating **	M	Issue No.	1231
LM End	15.58	Issue Type +	En	Location *	CR
Category	Supplemental			GPS Latitude/Longitude	
				Start	End
Item	DWR UCIP Field Study			37.228155 °	37.228155 °
				-120.802645 °	-120.802645 °
DWR ID					
Action/Comments					
Inspector Comments: FS_ID:36169					
DS_ID:19644					
EP_NO: N/A					
FS_HLM: 15.58					
Repair Type: Non-Urgent					
Crossing Status: Found

Concrete headwall visible on landward toe--dense vegetation blocking inlet.

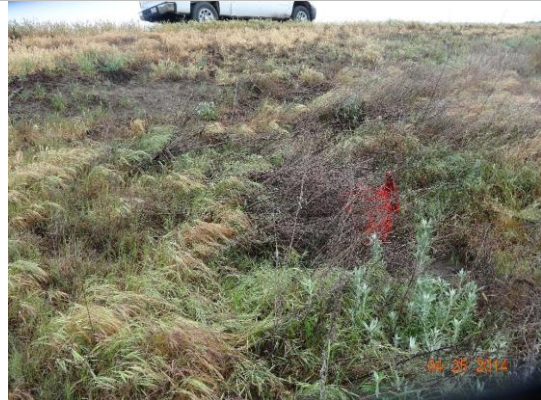
Photo 2 of 3 : UCIP_FA_2015_4986.jpg

View of waterward slope covered by dense vegetation.

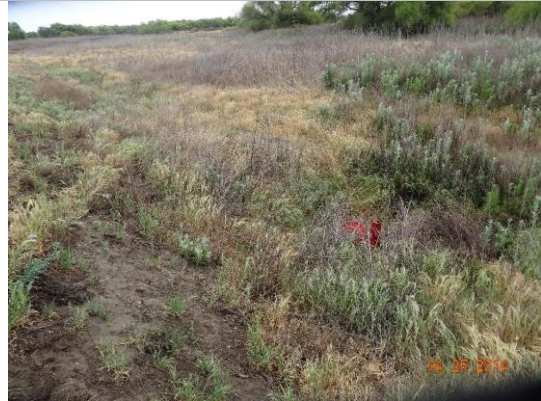
Photo 3 of 3 : UCIP_FA_2015_4987.jpg

LM Start	15.58	Rating **	M	Issue No.	1231 (cont)
LM End	15.58	Issue Type +	En	Location *	CR
Category	Supplemental			GPS Latitude/Longitude	
				Start	End
Item	DWR UCIP Field Study			37.228155 °	37.228155
				-120.802645 °	-120.802645
DWR ID					
Action/Comments					
Inspector Comments: FS_ID:36169					
DS_ID:19644					
EP_NO: N/A					
FS_HLM: 15.58					
Repair Type: Non-Urgent					
Crossing Status: Found

View of waterward side--flap gate visible through dense vegetation.

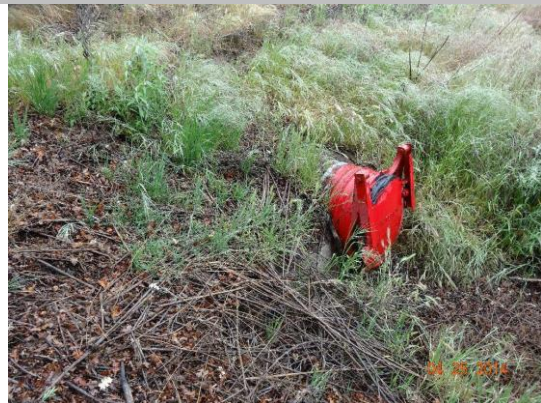
Photo 1 of 3 : UCIP_FA_2015_4988.jpg

LM Start	15.82	Rating **	M	Issue No.	1232
LM End	15.82	Issue Type +	En	Location *	CR
Category	Supplemental			GPS Latitude/Longitude	
				Start	End
Item	DWR UCIP Field Study			37.226099 °	37.226099 °
				-120.799125 °	-120.799125 °
DWR ID					
Action/Comments					
Inspector Comments: FS_ID:36171 DS_ID:19645 EP_NO: N/A FS_HLM: 15.82 Repair Type: Non-Urgent Crossing Status: Found UCIP Comments: Dense vegetation limits the inspector's visibility to identify signs of pipe failure (leaks) along the waterward and landward slope. Recommend removing vegetation along pipe alignment to conduct proper inspection of structure. FIELD_STRUCT_DESC: 24-inch CM pipe through the levee, 11.0 feet below the crown. Flap gate on the waterward end. Brass cap No. 60 BM on headwall on the landward side. (USACE-1967). This entry matches the Drainage or Irrigation Structure referenced in O&M manual (HLM 15.81). FS Date: 04/25/2014

Side view of pipe and flap gate on waterward side.

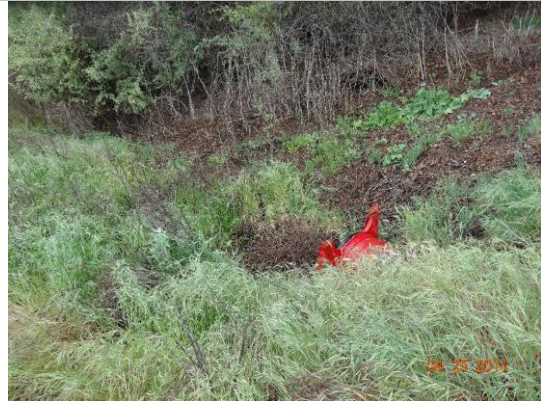
Photo 2 of 3 : UCIP_FA_2015_4989.jpg

LM Start	15.82	Rating **	M	Issue No.	1232 (cont)
LM End	15.82	Issue Type +	En	Location *	CR
Category	Supplemental			GPS Latitude/Longitude	
				Start	End
Item	DWR UCIP Field Study			37.226099 °	37.226099 °
				-120.799125 °	-120.799125 °
DWR ID					
Action/Comments					
Inspector Comments: FS_ID:36171 DS_ID:19645 EP_NO: N/A FS_HLM: 15.82 Repair Type: Non-Urgent Crossing Status: Found UCIP Comments: Dense vegetation limits the inspector's visibility to identify signs of pipe failure (leaks) along the waterward and landward slope. Recommend removing vegetation along pipe alignment to conduct proper inspection of structure. FIELD_STRUCT_DESC: 24-inch CM pipe through the levee, 11.0 feet below the crown. Flap gate on the waterward end. Brass cap No. 60 BM on headwall on the landward side. (USACE-1967). This entry matches the Drainage or Irrigation Structure referenced in O&M manual (HLM 15.81). FS Date: 04/25/2014

Flap gate visible on waterward side.

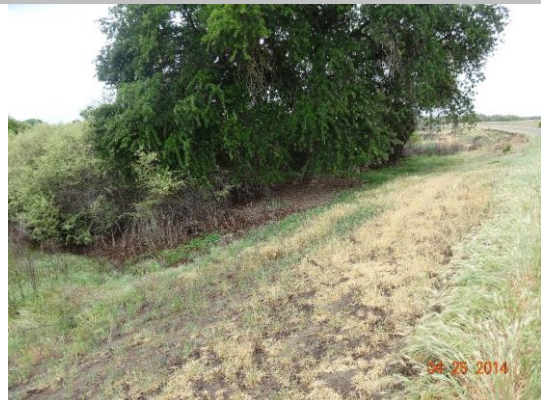
Photo 3 of 3 : UCIP_FA_2015_4990.jpg

View of waterward side.

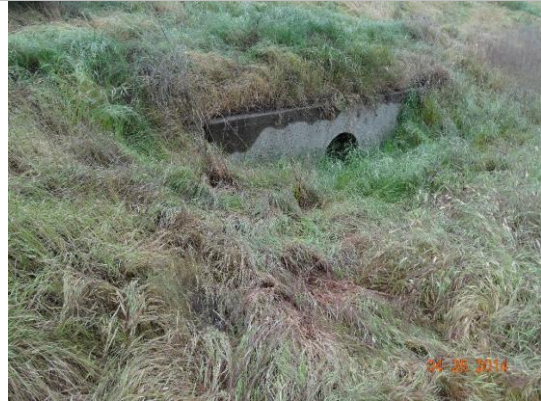
Photo 1 of 3 : UCIP_FA_2015_4991.jpg

LM Start	16.09	Rating **	M	Issue No.	1233
LM End	16.09	Issue Type +	En	Location *	CR
Category	Supplemental			GPS Latitude/Longitude	
				Start	End
Item	DWR UCIP Field Study			37.224157 °	37.224157 °
				-120.795250 °	-120.795250 °
DWR ID					
Action/Comments					
Inspector Comments: FS_ID:36172					
DS_ID:19646					
EP_NO: N/A					
FS_HLM: 16.09					
Repair Type: Non-Urgent					
Crossing Status: Found

View of landward side.

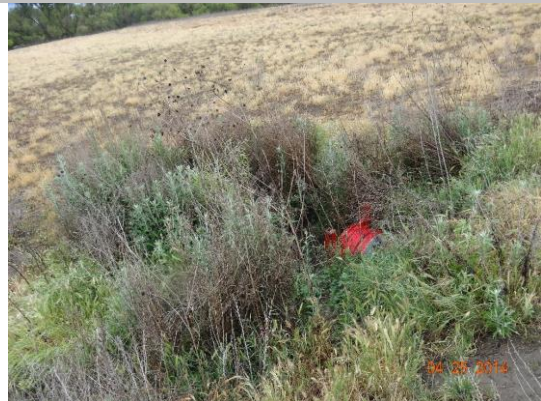
Photo 2 of 3 : UCIP_FA_2015_4992.jpg

Flap gate visible on waterward toe.

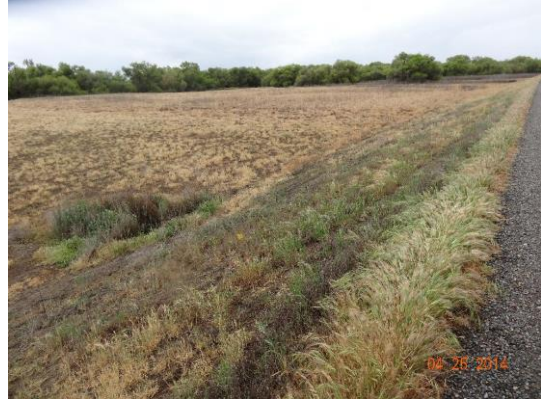
Photo 3 of 3 : UCIP_FA_2015_4993.jpg

LM Start	16.09	Rating **	M	Issue No.	1233 (cont)
LM End	16.09	Issue Type +	En	Location *	CR
Category	Supplemental			GPS Latitude/Longitude	
				Start	End
Item	DWR UCIP Field Study			37.224157 °	37.224157 °
				-120.795250 °	-120.795250 °
DWR ID					
Action/Comments					
Inspector Comments: FS_ID:36172					
DS_ID:19646					
EP_NO: N/A					
FS_HLM: 16.09					
Repair Type: Non-Urgent					
Crossing Status: Found

View of waterward side.

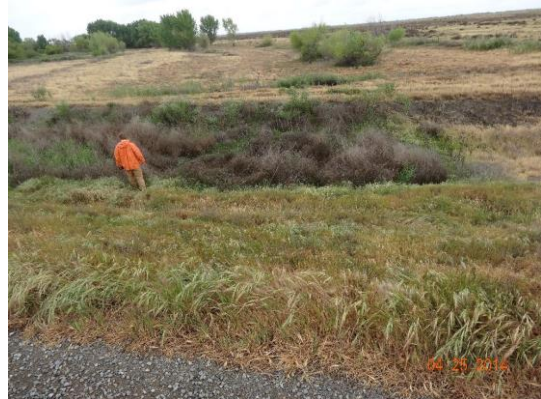
Photo 1 of 3 : UCIP_FA_2015_4994.jpg

LM Start	16.15	Rating **	M	Issue No.	1234
LM End	16.15	Issue Type +	En	Location *	CR
Category	Supplemental			GPS Latitude/Longitude	
				Start	End
Item	DWR UCIP Field Study			37.224120 °	37.224120 °
				-120.794002 °	-120.794002 °
DWR ID					
Action/Comments					
Inspector Comments: FS_ID:39257 DS_ID:19647 EP_NO: N/A FS_HLM: 16.16 Repair Type: Non-Urgent Crossing Status: Found UCIP Comments: Dense vegetation limits the inspector's visibility to identify signs of pipe failure (leaks) along the waterward and landward slopes. Recommend removing vegetation along pipe alignment to conduct proper inspection of structure. Unable to find pipe on landward side. FIELD_STRUCT_DESC: 24-inch CM pipe through the levee, 14.7 feet below the crown. Flap gate on the waterward end. Brass cap No. 50 BM on headwall on the landward side. (USACE-1967). This entry matches the Drainage or Irrigation Structure referenced in O&M manual (HLM 16.15). FS Date: 04/25/2014

View of landward side.

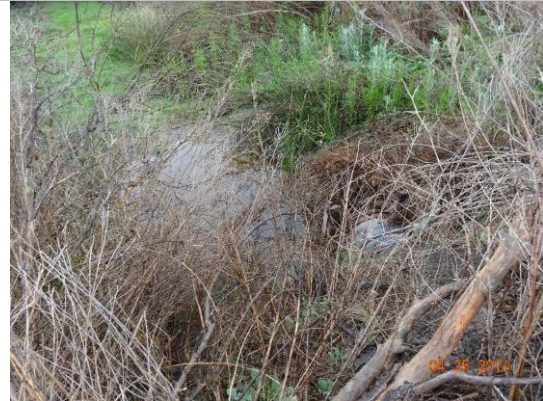
Photo 2 of 3 : UCIP_FA_2015_4995.jpg

Inspector Comments: FS_ID:39257
DS_ID:19647
EP_NO: N/A
FS_HLM: 16.16
Repair Type: Non-Urgent
Crossing Status: Found
UCIP Comments: Dense vegetation limits the inspector's visibility to identify signs of pipe failure (leaks) along the waterward and landward slopes. Recommend removing vegetation along pipe alignment to conduct proper inspection of structure. Unable to find pipe on landward side.
FIELD_STRUCT_DESC: 24-inch CM pipe through the levee, 14.7 feet below the crown. Flap gate on the waterward end. Brass cap No. 50 BM on headwall on the landward side. (USACE-1967). This entry matches the Drainage or Irrigation Structure referenced in O&M manual (HLM 16.15).
FS Date: 04/25/2014

Crossing visible on waterward side under dense vegetation.

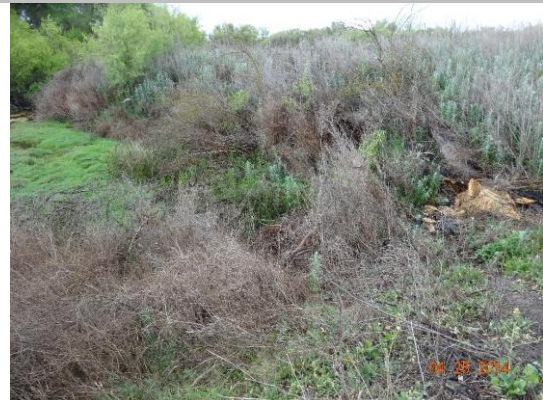
Photo 3 of 3 : UCIP_FA_2015_4996.jpg

View of waterward side.

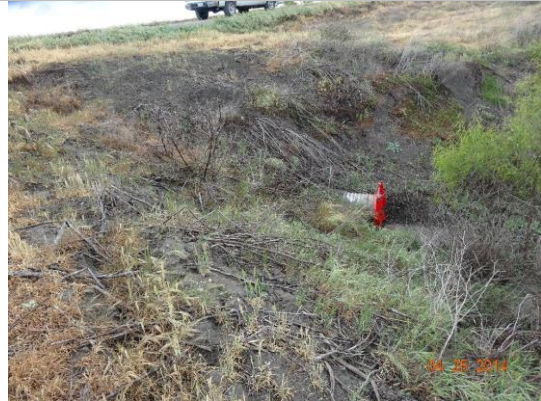
Photo 1 of 3 : UCIP_FA_2015_4802.jpg

LM Start	16.72	Rating **	M	Issue No.	1235
LM End	16.72	Issue Type +	En	Location *	CR
Category	Supplemental			GPS Latitude/Longitude	
				Start	End
Item	DWR UCIP Field Study			37.224223 °	37.224223 °
				-120.783806 °	-120.783806 °
DWR ID					
Action/Comments					
Inspector Comments: FS_ID:39258					
DS_ID:19648					
EP_NO: N/A					
FS_HLM: 16.732					
Repair Type: Non-Urgent					
Crossing Status: Found

View of flap gate visible on waterward side.

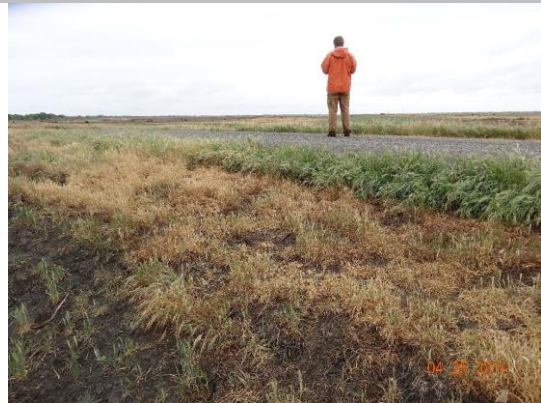
Photo 2 of 3 : UCIP_FA_2015_4803.jpg

View of levee crown at crossing.
