**Flood Control Project Maintenance
Levee Inspections**

Fall 2015 Levee Maintenance Deficiency Summary Report

San Joaquin River Basin

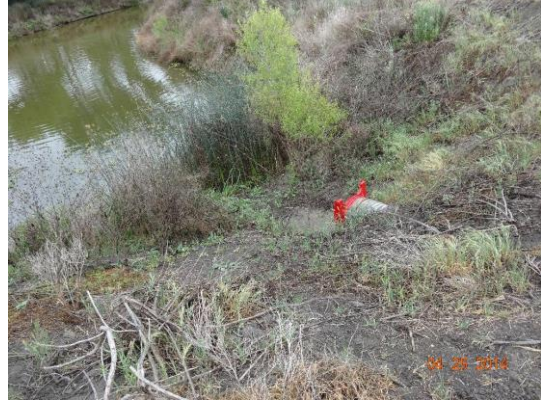
Photo 3 of 3 : UCIP_FA_2015_4804.jpg

LM Start	16.72	Rating **	M	Issue No.	1235 (cont)
LM End	16.72	Issue Type +	En	Location *	CR
Category	Supplemental			GPS Latitude/Longitude	
				Start	End
Item	DWR UCIP Field Study			37.224223 °	37.224223 °
				-120.783806 °	-120.783806 °
DWR ID					
Action/Comments					
Inspector Comments: FS_ID:39258 DS_ID:19648 EP_NO: N/A FS_HLM: 16.732 Repair Type: Non-Urgent Crossing Status: Found

View of waterward side.

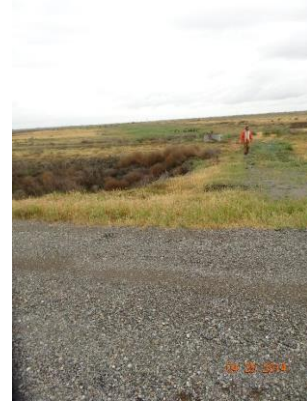
Photo 1 of 2 : UCIP_FA_2015_6418.jpg

LM Start	16.72	Rating **	M	Issue No.	1236
LM End	16.72	Issue Type +	En	Location *	CR
Category	Supplemental			GPS Latitude/Longitude	
				Start	End
Item	DWR UCIP Field Study			37.224223 °	37.224223 °
				-120.783806 °	-120.783806 °
DWR ID					
Action/Comments					
Inspector Comments: FS_ID:39360 DS_ID:24870 EP_NO: N/A FS_HLM: 16.732 Repair Type: Non-Urgent Crossing Status: Found UCIP Comments: Need to contact owner to determine status and reason for crossing. FIELD_STRUCT_DESC: 12-inch steel pipe through the levee at an unknown depth. Concrete standpipe visible on landward side. FS Date: 04/25/2014

View of landward side.

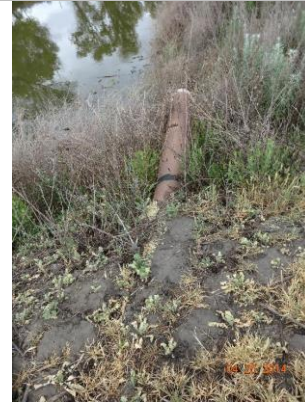
Photo 2 of 2 : UCIP_FA_2015_6419.jpg

LM Start	16.72	Rating **	M	Issue No.	1236 (cont)
LM End	16.72	Issue Type +	En	Location *	CR
Category	Supplemental			GPS Latitude/Longitude	
				Start	End
Item	DWR UCIP Field Study			37.224223 °	37.224223 °
				-120.783806 °	-120.783806 °
DWR ID					
Action/Comments					
Inspector Comments: FS_ID:39360 DS_ID:24870 EP_NO: N/A FS_HLM: 16.732 Repair Type: Non-Urgent Crossing Status: Found UCIP Comments: Need to contact owner to determine status and reason for crossing. FIELD_STRUCT_DESC: 12-inch steel pipe through the levee at an unknown depth. Concrete standpipe visible on landward side. FS Date: 04/25/2014

View of pipe located on waterward side.

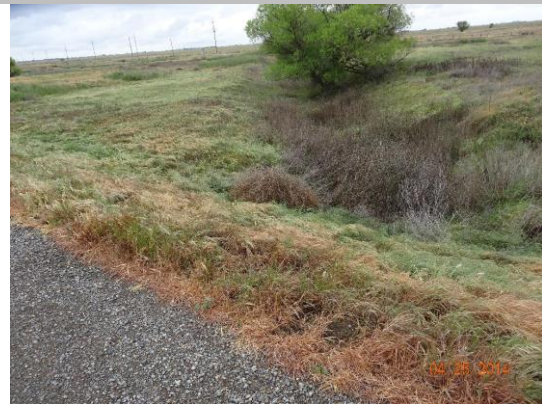
Photo 1 of 3 : UCIP_FA_2015_3766.jpg

LM Start	17.01	Rating **	M	Issue No.	1237
LM End	17.01	Issue Type +	En	Location *	CR
Category	Supplemental			GPS Latitude/Longitude	
				Start	End
Item	DWR UCIP Field Study			37.221838 °	37.221838 °
				-120.780230 °	-120.780230 °
DWR ID					
Action/Comments					
Inspector Comments: FS_ID:39259 DS_ID:19577 EP_NO: N/A FS_HLM: 17.02 Repair Type: Non-Urgent Crossing Status: Found UCIP Comments: Dense vegetation limits the inspector's visibility to identify signs of pipe failure (leaks) along the waterward and landward slopes. Concrete headwall is buried by dense vegetation. Recommend removing vegetation along pipe alignment to conduct proper inspection of structure. FIELD_STRUCT_DESC: 24-inch CM pipe through the levee, 11.5 feet below the crown. Flap gate on the waterward end. Brass cap No. 50 BM on headwall on the landward side. (USACE-1967). This entry matches the Drainage or Irrigation Structure referenced in O&M manual (HLM 17.01). FS Date: 04/25/2014

View of landward side.

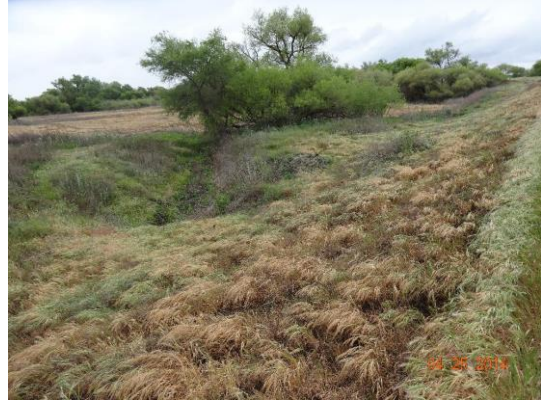
Photo 2 of 3 : UCIP_FA_2015_3767.jpg

LM Start	17.01	Rating **	M	Issue No.	1237 (cont)
LM End	17.01	Issue Type +	En	Location *	CR
Category	Supplemental			GPS Latitude/Longitude	
				Start	End
Item	DWR UCIP Field Study			37.221838 °	37.221838 °
				-120.780230 °	-120.780230 °
DWR ID					
Action/Comments					
Inspector Comments: FS_ID:39259 DS_ID:19577 EP_NO: N/A FS_HLM: 17.02 Repair Type: Non-Urgent Crossing Status: Found UCIP Comments: Dense vegetation limits the inspector's visibility to identify signs of pipe failure (leaks) along the waterward and landward slopes. Concrete headwall is buried by dense vegetation. Recommend removing vegetation along pipe alignment to conduct proper inspection of structure. FIELD_STRUCT_DESC: 24-inch CM pipe through the levee, 11.5 feet below the crown. Flap gate on the waterward end. Brass cap No. 50 BM on headwall on the landward side. (USACE-1967). This entry matches the Drainage or Irrigation Structure referenced in O&M manual (HLM 17.01). FS Date: 04/25/2014

View of waterward side.

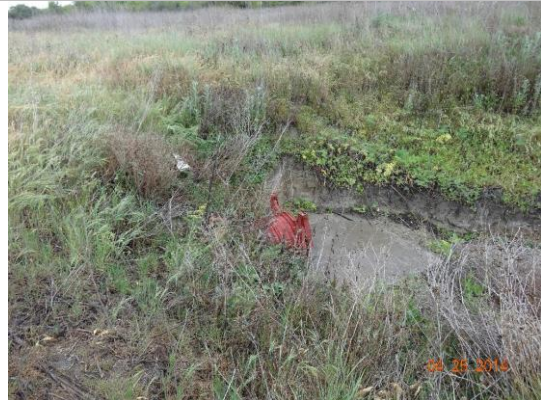
Photo 3 of 3 : UCIP_FA_2015_3768.jpg

Flap gate visible on waterward side.

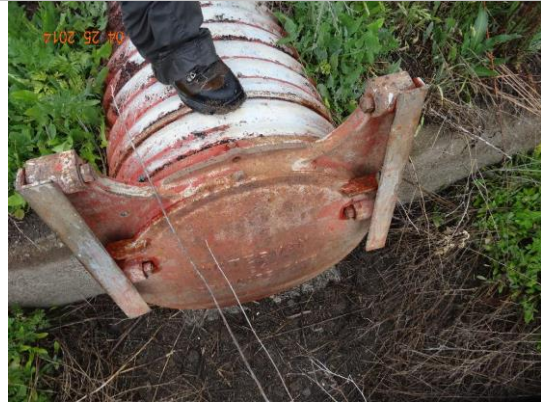
Photo 1 of 3 : UCIP_FA_2015_5326.jpg

LM Start	17.19	Rating **	M	Issue No.	1238
LM End	17.19	Issue Type +	En	Location *	CR
Category	Supplemental			GPS Latitude/Longitude	
				Start	End
Item	DWR UCIP Field Study			37.219302 °	37.219302 °
				-120.779475 °	-120.779475 °
DWR ID					
Action/Comments					
Inspector Comments: FS_ID:39260					
DS_ID:19578					
EP_NO: N/A					
FS_HLM: 17.2					
Repair Type: Non-Urgent					
Crossing Status: Found

Flap gate visible on waterward toe.

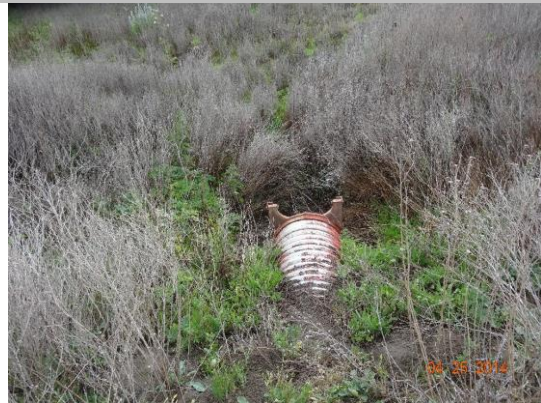
Photo 2 of 3 : UCIP_FA_2015_5327.jpg

Pipe visible on waterward side.

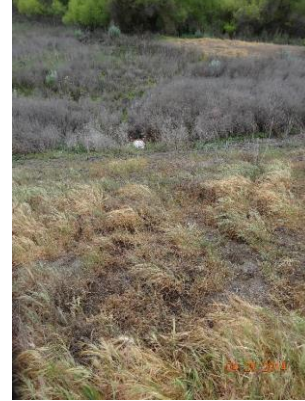
Photo 3 of 3 : UCIP_FA_2015_5328.jpg

View of waterward side.

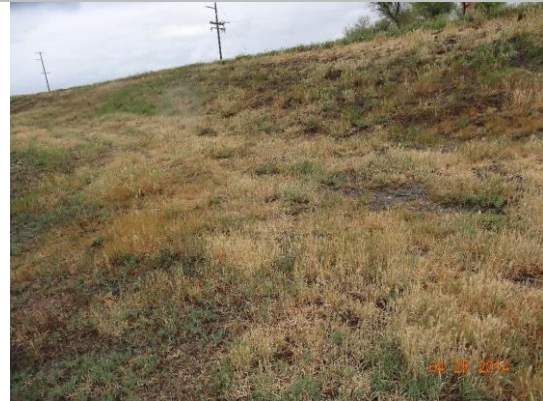
Photo 1 of 3 : UCIP_FA_2015_5330.jpg

LM Start	17.26	Rating **	M	Issue No.	1239
LM End	17.26	Issue Type +	En	Location *	CR
Category	Supplemental			GPS Latitude/Longitude	
				Start	End
Item	DWR UCIP Field Study			37.218332 °	37.218332 °
				-120.779459 °	-120.779459 °
DWR ID					
Action/Comments					
Inspector Comments: FS_ID:36203 DS_ID:19579 EP_NO: N/A FS_HLM: 17.26 Repair Type: Non-Urgent Crossing Status: Found UCIP Comments: Dense vegetation limits the inspector's visibility to identify signs of pipe failure (leaks) along the waterward and landward slope. Recommend removing vegetation along pipe alignment to conduct proper inspection of structure. FIELD_STRUCT_DESC: 24-inch CM pipe through the levee, 15.8 feet below the crown. Flap gate on the waterward end. Brass cap No. 50 BM on headwall on the landward side. (USACE-1967). This entry matches the Drainage or Irrigation Structure referenced in O&M manual (HLM 17.26). FS Date: 04/25/2014

View of waterward slope.

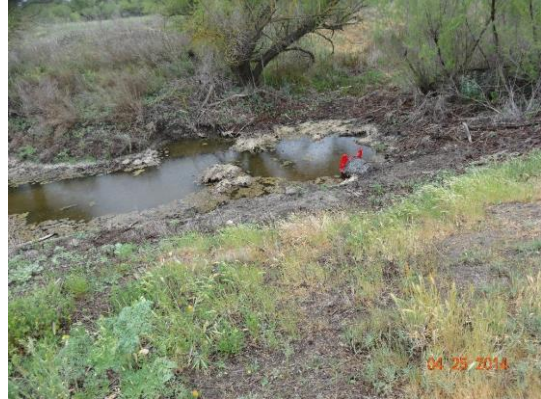
Photo 2 of 3 : UCIP_FA_2015_5331.jpg

Pipe visible on waterward side.

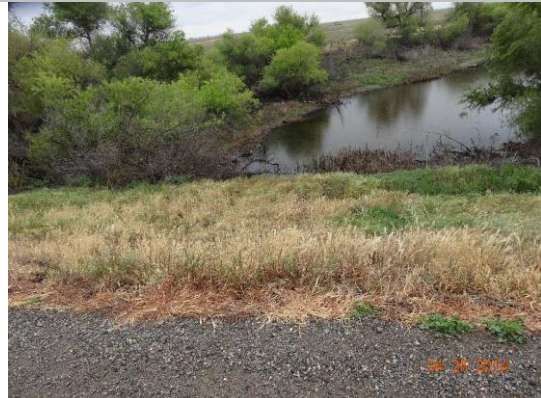
Photo 3 of 3 : UCIP_FA_2015_5336.jpg

View of landward side.

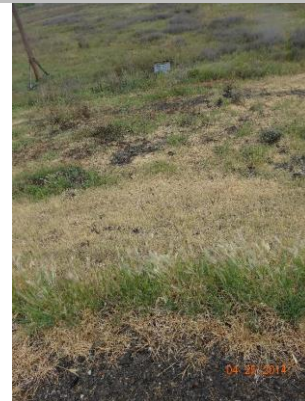
Photo 1 of 3 : UCIP_FA_2015_5333.jpg

LM Start	17.52	Rating **	M	Issue No.	1240
LM End	17.52	Issue Type +	En	Location *	LS
Category	Supplemental			GPS Latitude/Longitude	
				Start	End
Item	DWR UCIP Field Study			37.215976 °	37.215976 °
				-120.777615 °	-120.777615 °
DWR ID					
Action/Comments					
Inspector Comments: FS_ID:36204					
DS_ID:19580					
EP_NO: N/A					
FS_HLM: 17.53					
Repair Type: Non-Urgent					
Crossing Status: Found					
UCIP Comments: Dense vegetation limits the inspector's visibility to identify signs of pipe failure (leaks) along the landward slope.					
Recommend removing vegetation along pipe alignment to conduct proper inspection of structure.					
FIELD_STRUCT_DESC: 24-inch CM pipe through the levee, 9.5 feet below the crown. Flap gate on the waterward end. Brass cap No. 50 BM on headwall on the landward side. (USACE-1967). This entry matches the Drainage or Irrigation Structure referenced in O&M manual (HLM 17.53).

View of landward side--riser at levee toe.

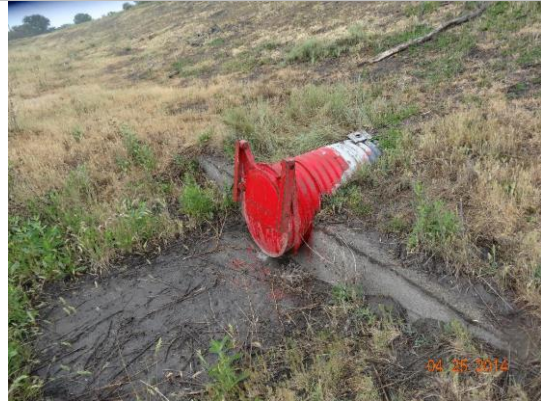
Photo 2 of 3 : UCIP_FA_2015_5334.jpg

Flap gate visible on waterward side.

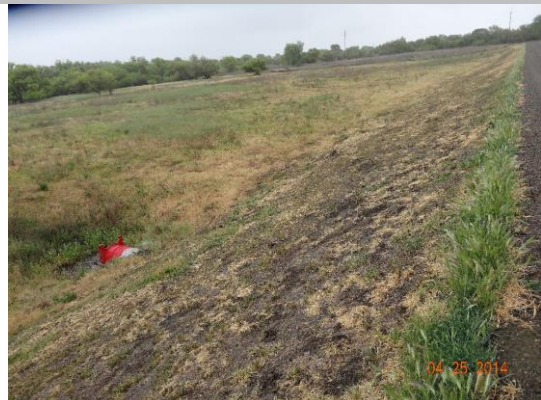
Photo 3 of 3 : UCIP_FA_2015_5335.jpg

View of waterward side.

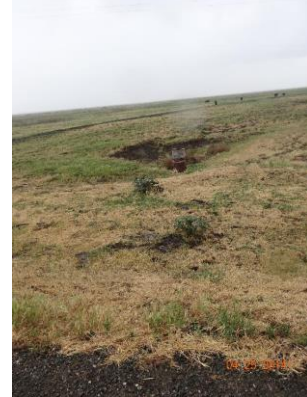
Photo 1 of 3 : UCIP_FA_2015_5329.jpg

LM Start	18.18	Rating **	M	Issue No.	1241
LM End	18.18	Issue Type +	En	Location *	LS
Category	Supplemental			GPS Latitude/Longitude	
				Start	End
Item	DWR UCIP Field Study			37.210998 °	37.210998 °
				-120.768900 °	-120.768900 °
DWR ID					
Action/Comments					
Inspector Comments: FS_ID:39261 DS_ID:19581 EP_NO: N/A FS_HLM: 18.19 Repair Type: Non-Urgent Crossing Status: Found

View of landward side.

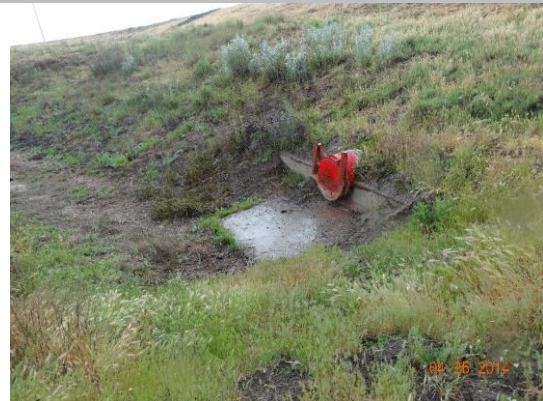
Photo 2 of 3 : UCIP_FA_2015_5332.jpg

Flap gate visible on waterward side.

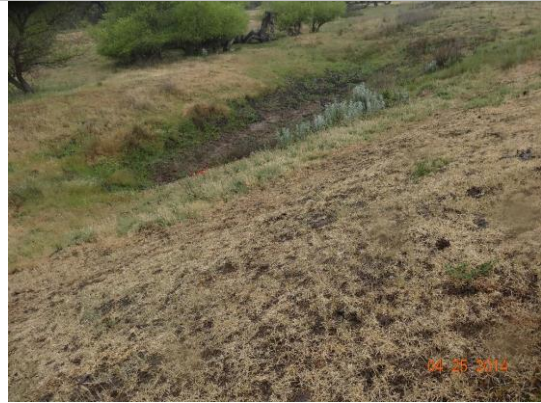
Photo 3 of 3 : UCIP_FA_2015_5337.jpg

View of waterward side.

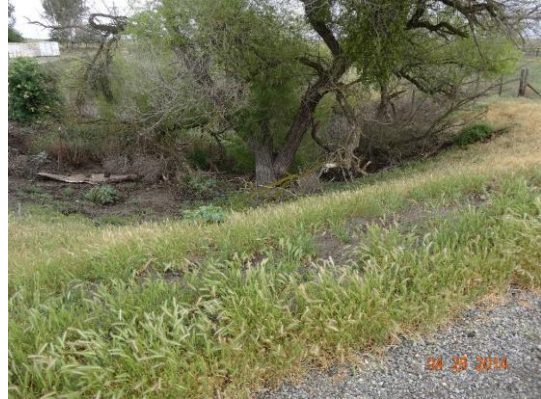
Photo 1 of 3 : UCIP_FA_2015_3769.jpg

LM Start	18.78	Rating **	M	Issue No.	1242
LM End	18.78	Issue Type +	En	Location *	WS
Category	Supplemental			GPS Latitude/Longitude	
				Start	End
Item	DWR UCIP Field Study			37.204966 °	37.204966 °
				-120.762511 °	-120.762511 °
DWR ID					
Action/Comments					
Inspector Comments: FS_ID:36246 DS_ID:19593 EP_NO: N/A FS_HLM: 18.79 Repair Type: Non-Urgent Crossing Status: Found UCIP Comments: Dense vegetation limits the inspector's visibility to identify signs of pipe failure (leaks) along the landward slope. Recommend removing vegetation along pipe alignment to conduct proper inspection of structure. FIELD_STRUCT_DESC: 24-inch CM pipe through the levee, 12.0 feet below the crown. Flap gate on the waterward end. Brass cap No. 50 BM on headwall on the landward side. (USACE-1967). This entry matches the Drainage or Irrigation Structure referenced in O&M manual (HLM 18.79). FS Date: 04/25/2014

Overview of landward side.

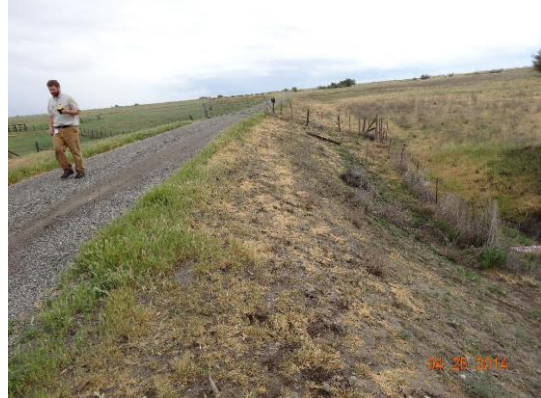
Photo 2 of 3 : UCIP_FA_2015_3770.jpg

Overview of levee crown and waterward slope.

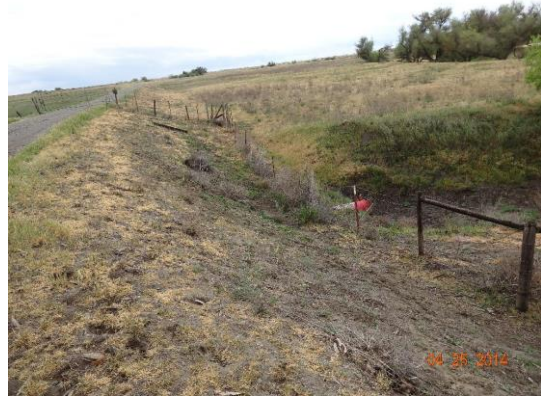
Photo 3 of 3 : UCIP_FA_2015_5359.jpg

View of waterward side.

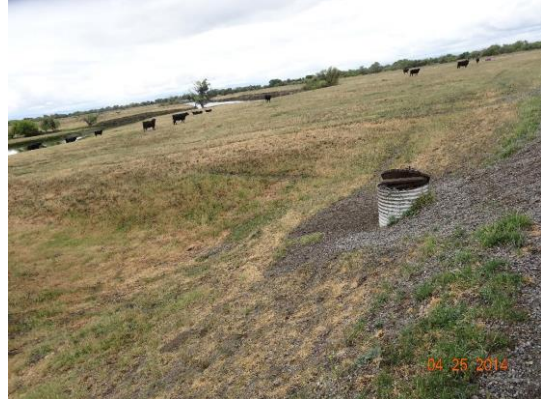
Photo 1 of 3 : UCIP_FA_2015_3771.jpg

LM Start	19.17	Rating **	M	Issue No.	1243
LM End	19.17	Issue Type +	En	Location *	WS
Category	Supplemental			GPS Latitude/Longitude	
				Start	End
Item	DWR UCIP Field Study			37.202801 °	37.202801 °
				-120.756209 °	-120.756209 °
DWR ID					
Action/Comments					
Inspector Comments: FS_ID:39263 DS_ID:19594 EP_NO: N/A FS_HLM: 19.18 Repair Type: Non-Urgent Crossing Status: Found UCIP Comments: Non-functional crossing--pipe is buried on waterward side. Sediment buildup in pipe visible from landward side. Need to coordinate with owner to determine status. If crossing is no longer in use, owner will need to coordinate with DWR Inspector and CVFPB to properly abandon. FIELD_STRUCT_DESC: 24-inch CM pipe through the levee, 13.0 feet below the crown. Slide gate on the waterward slope. Brass cap No. 40 BM on headwall on the landward side. (USACE-1967). This entry matches the Drainage or Irrigation Structure referenced in O&M manual (HLM 19.17). FS Date: 04/25/2014

View of waterward side.

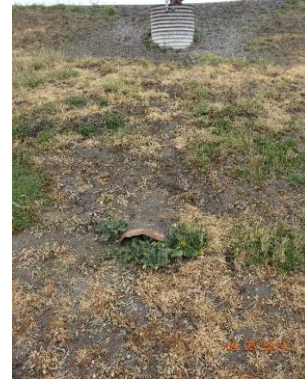
Photo 2 of 3 : UCIP_FA_2015_3772.jpg

View of waterward slope. CMP riser and pipe visible.

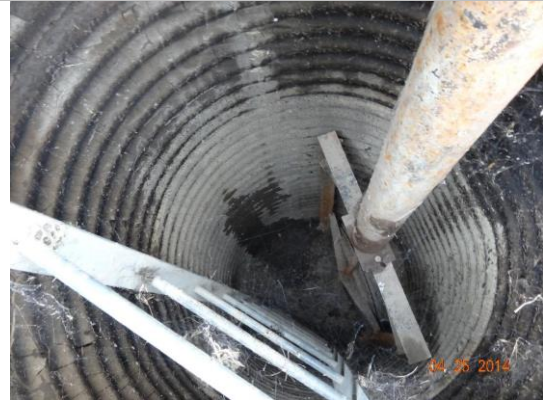
Photo 3 of 3 : UCIP_FA_2015_5434.jpg

Inside view of CMP riser.

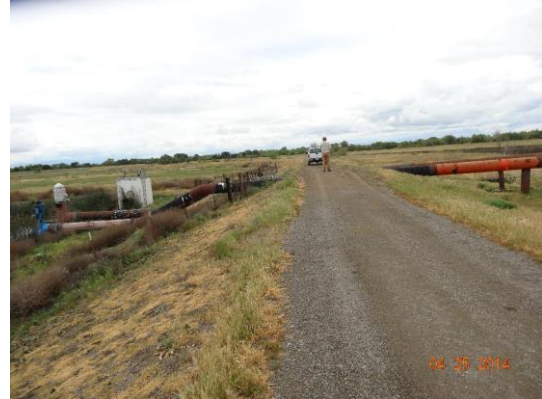
Photo 1 of 3 : UCIP_FA_2015_5888.jpg

LM Start	19.32	Rating **	M	Issue No.	1244
LM End	19.32	Issue Type +	En	Location *	WS
Category	Supplemental			GPS Latitude/Longitude	
				Start	End
Item	DWR UCIP Field Study			37.200921 °	37.200921 °
				-120.756901 °	-120.756901 °
DWR ID					
Action/Comments					
Inspector Comments: FS_ID:39266					
DS_ID:24871					
EP_NO: N/A					
FS_HLM: 19.321					
Repair Type: Non-Urgent					
Crossing Status: Found

Overview of levee crown at crossing.

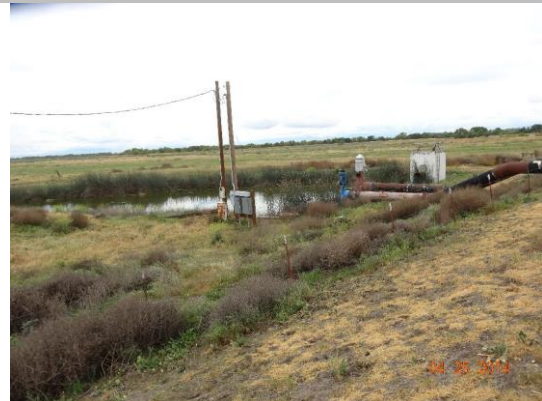
Photo 2 of 3 : UCIP_FA_2015_5889.jpg

View of landward side.

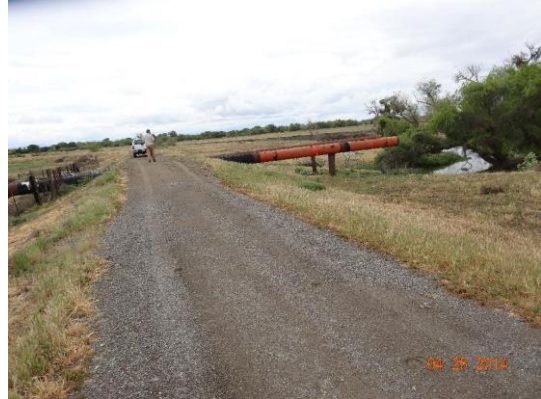
Photo 3 of 3 : UCIP_FA_2015_5890.jpg

View of waterward slope.

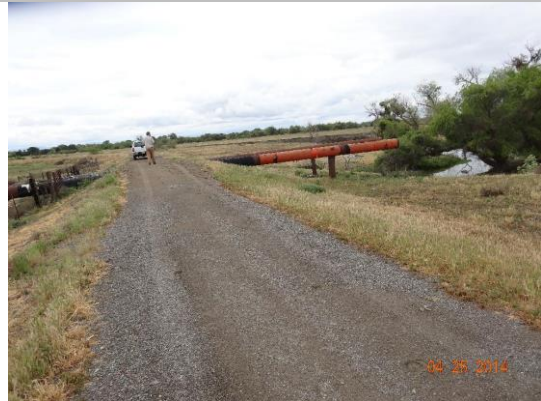
Photo 1 of 3 : UCIP_FA_2015_5891.jpg

LM Start	19.32	Rating **	M	Issue No.	1245
LM End	19.32	Issue Type +	En	Location *	WS
Category	Supplemental			GPS Latitude/Longitude	
				Start	End
Item	DWR UCIP Field Study			37.200919 °	37.200919 °
				-120.756928 °	-120.756928 °
DWR ID					
Action/Comments					
Inspector Comments: FS_ID:39267 DS_ID:24872 EP_NO: N/A FS_HLM: 19.322 Repair Type: Non-Urgent Crossing Status: Found UCIP Comments: New crossing found during field inspection--Need to contact owner to obtain additional information about crossing. FIELD_STRUCT_DESC: 2 of 2: 20-inch steel pipe through levee at an unknown depth. Pump station located on landward side. Electrical panel located on landward side. FS Date: 04/25/2014

View of waterward slope.

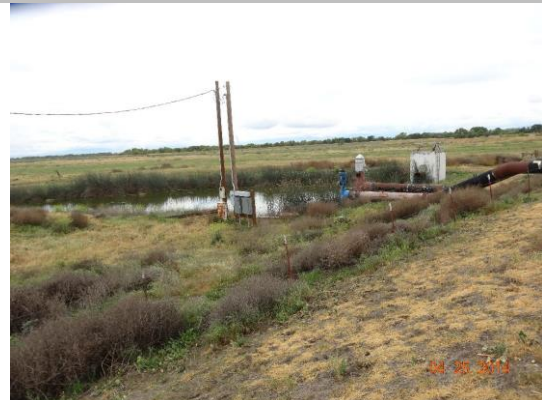
Photo 3 of 3 : UCIP_FA_2015_5916.jpg

Action/Comments					
Inspector Comments: FS_ID:39267 DS_ID:24872 EP_NO: N/A FS_HLM: 19.322 Repair Type: Non-Urgent Crossing Status: Found UCIP Comments: New crossing found during field inspection--Need to contact owner to obtain additional information about crossing. FIELD_STRUCT_DESC: 2 of 2: 20-inch steel pipe through levee at an unknown depth. Pump station located on landward side. Electrical panel located on landward side. FS Date: 04/25/2014

View of landward side.

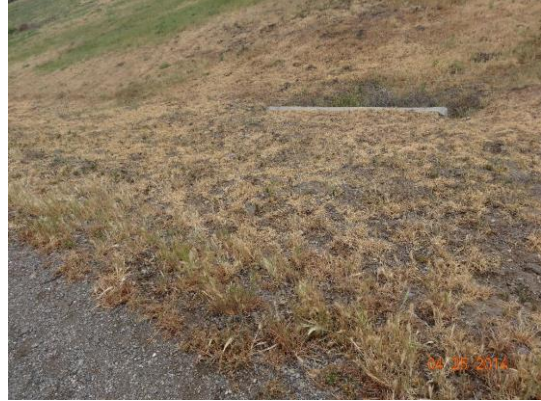
Photo 1 of 3 : UCIP_FA_2015_5435.jpg

LM Start	19.53	Rating **	M	Issue No.	1246
LM End	19.53	Issue Type +	En	Location *	WS
Category	Supplemental			GPS Latitude/Longitude	
				Start	End
Item	DWR UCIP Field Study			37.199427 °	37.199427 °
				-120.760235 °	-120.760235 °
DWR ID					
Action/Comments					
Inspector Comments: FS_ID:39268					
DS_ID:19596					
EP_NO: N/A					
FS_HLM: 19.54					
Repair Type: Non-Urgent					
Crossing Status: Found

View of landward slope.

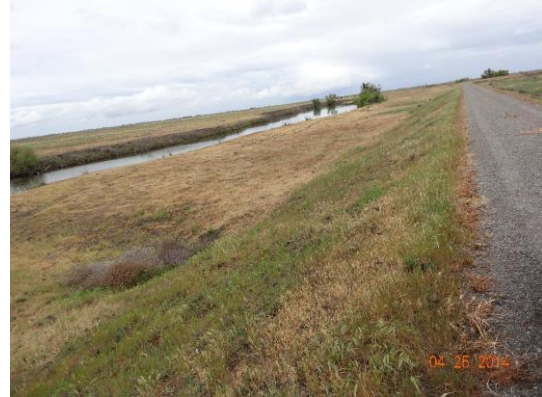
Photo 3 of 3 : UCIP_FA_2015_5437.jpg

View of waterward side.

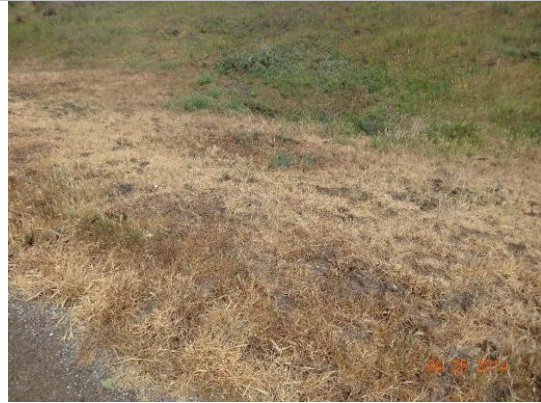
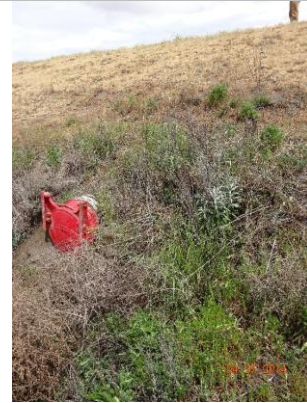
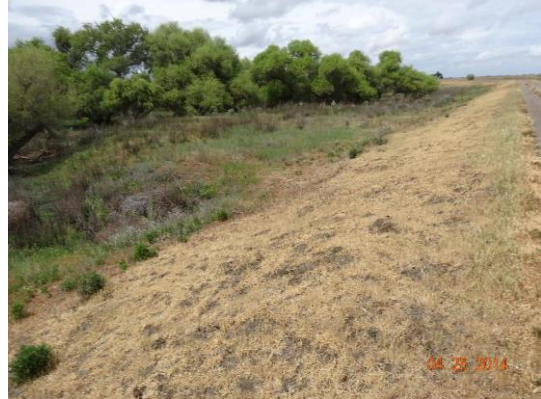
Action/Comments					
Inspector Comments: FS_ID:39269 DS_ID:19598 EP_NO: N/A FS_HLM: 20.18 Repair Type: Non-Urgent Crossing Status: Found UCIP Comments: Recommend removing vegetation and sediment buildup from both waterward and landward concrete headwalls. FIELD_STRUCT_DESC: 24-inch CM pipe through the levee, 8.5 feet below the crown. Flap gate on the waterward end. Brass cap No. 40 BM on headwall on the landward side. (USACE-1967). This entry matches the Drainage or Irrigation Structure referenced in O&M manual (HLM 20.18). FS Date: 04/25/2014

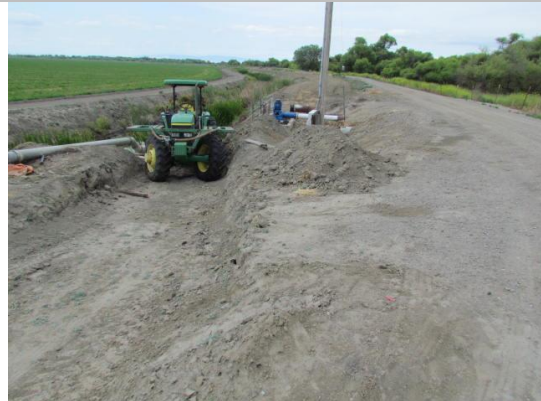
Photo 1 of 2 : FA_2015_NA0010_118_1184_20150914_00031.jpg

LM Start	20.25	Rating **	U	Issue No.	1184
LM End	20.25	Issue Type +	En	Location *	LS
Category	Earthen Levee			GPS Latitude/Longitude	
				Start	End
Item	Encroachments			37.193657 °	37.193657 °
				-120.760138 °	-120.760138 °
DWR ID	DWR_NA0010_01_s_2015_1184				
Action/Comments					
Ramp					
Inspector Comments: Landowner installed unauthorized ramp on landward slope and toe.

Looking north at ramp cut into landward slope.

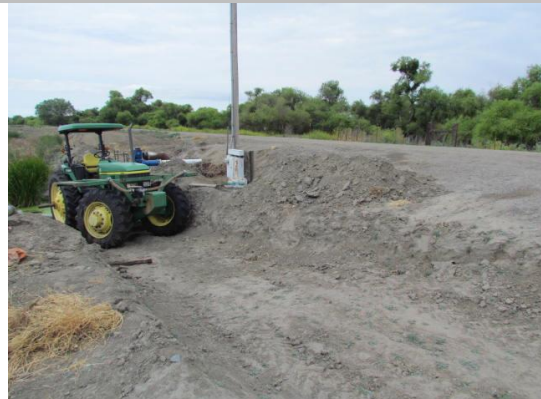
Photo 2 of 2 : FA_2015_NA0010_118_1184_20150914_00032.jpg

Looking east at ramp cut into landward slope.

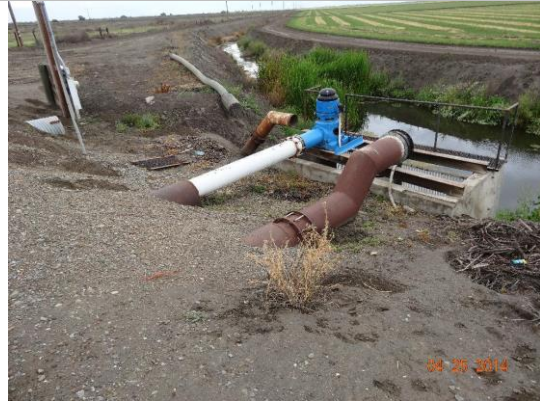
Photo 1 of 3 : UCIP_FA_2015_5495.jpg

View of landward side.

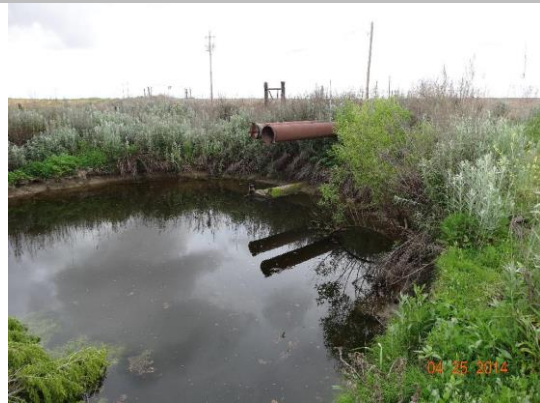
Photo 2 of 3 : UCIP_FA_2015_5496.jpg

View of waterward side.

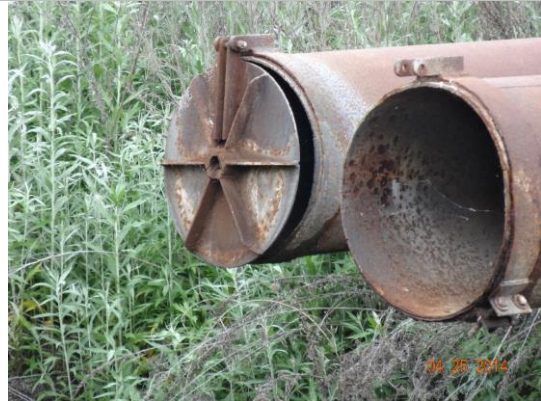
Photo 3 of 3 : UCIP_FA_2015_5497.jpg

Outlet visible on waterward side.

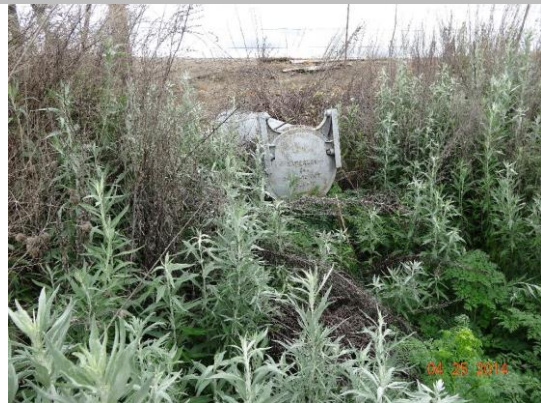
Photo 1 of 3 : UCIP_FA_2015_4911.jpg

LM Start	20.27	Rating **	U	Issue No.	1250
LM End	20.27	Issue Type +	En	Location *	LS
Category	Supplemental			GPS Latitude/Longitude	
				Start	End
Item	DWR UCIP Field Study			37.193542 °	37.193542 °
				-120.760300 °	-120.760300 °
DWR ID					
Action/Comments					
Inspector Comments: FS_ID:39270					
DS_ID:19599					
EP_NO: N/A					
FS_HLM: 20.27					
Repair Type: Urgent					
Crossing Status: Found					
UCIP Comments: Unauthorized crossing through pipe. Line was pushed through existing crossing. Need to contact owner. Also sediment buildup in pipe visible from landward side--recommend clearing.					
FIELD_STRUCT_DESC: 24-inch CM pipe through the levee, 5.0 feet below the crown. Flap gate on the waterward end.					
FS Date: 04/25/2014

View of waterward side.

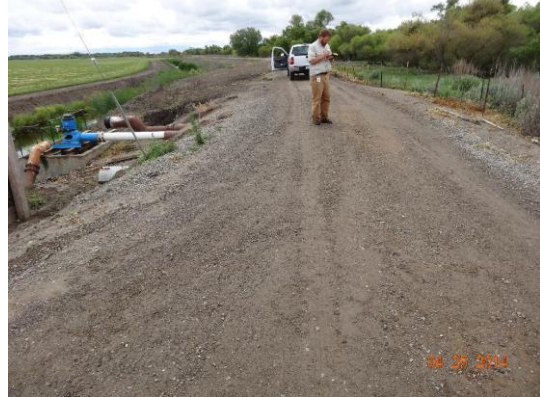
Photo 2 of 3 : UCIP_FA_2015_4912.jpg

Inspector Comments: FS_ID:39270
 DS_ID:19599
 EP_NO: N/A
 FS_HLM: 20.27
 Repair Type: Urgent
 Crossing Status: Found
 UCIP Comments: Unauthorized crossing through pipe. Line was pushed through existing crossing. Need to contact owner. Also sediment buildup in pipe visible from landward side--recommend clearing.
 FIELD_STRUCT_DESC: 24-inch CM pipe through the levee, 5.0 feet below the crown. Flap gate on the waterward end.
 FS Date: 04/25/2014

Overview of levee crown at crossing.

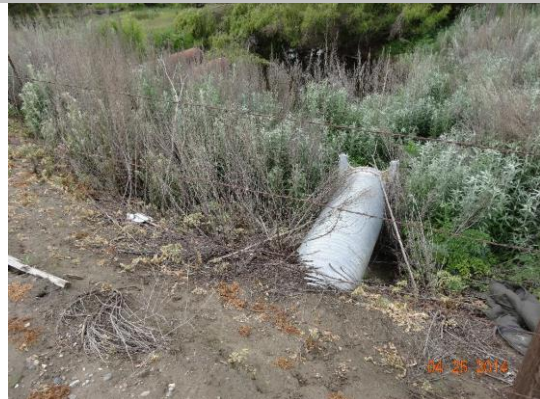
Photo 3 of 3 : UCIP_FA_2015_4913.jpg

View of waterward side.

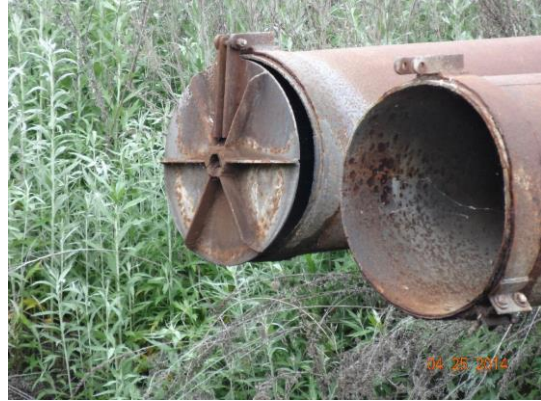
Photo 1 of 3 : UCIP_FA_2015_5494.jpg

Outlets visible on waterward side.

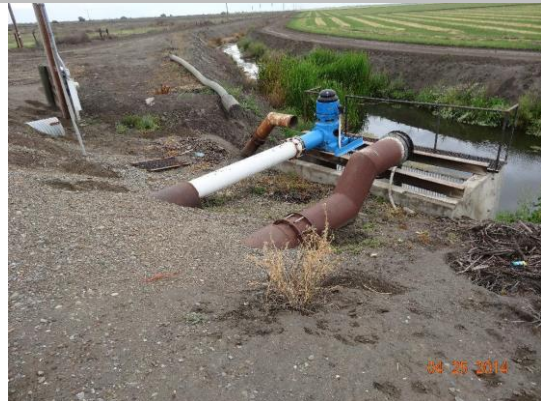
Photo 2 of 3 : UCIP_FA_2015_5917.jpg

View of landward side.

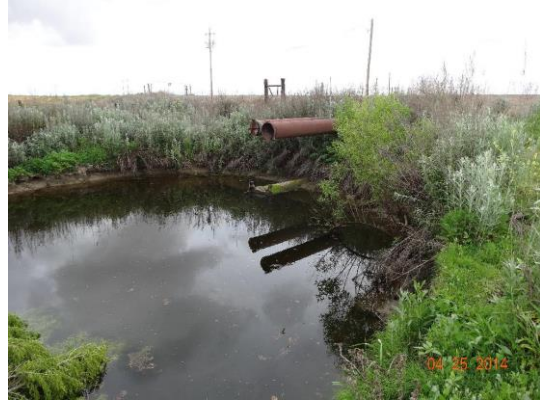
Photo 3 of 3 : UCIP_FA_2015_5918.jpg

View of waterward side.

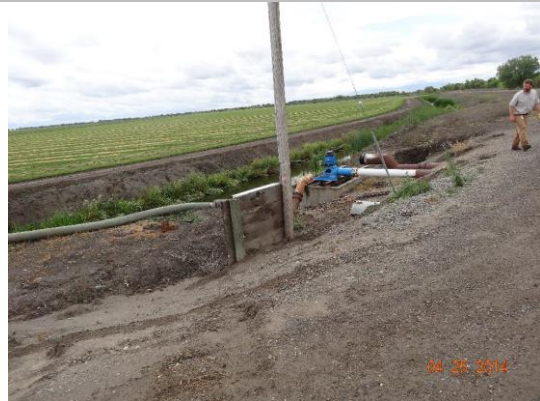
Photo 1 of 3 : UCIP_FA_2015_4914.jpg

LM Start	20.27	Rating **	M	Issue No.	1252
LM End	20.27	Issue Type +	En	Location *	LS
Category	Supplemental			GPS Latitude/Longitude	
				Start	End
Item	DWR UCIP Field Study			37.193542 °	37.193542 °
				-120.760300 °	-120.760300 °
DWR ID					
Action/Comments					
Inspector Comments: FS_ID:39878 DS_ID:19600 EP_NO: N/A FS_HLM: 20.273 Repair Type: Non-Urgent Crossing Status: Found UCIP Comments: Crossing partially submersed--no signs of failure of pipe present along pipe alignment. Recommend contacting owner to determine status of crossing and condition. FIELD_STRUCT_DESC: 36-inch CM pipe through the levee, 10.5 feet below the crown. Flap gate on the waterward end. Brass cap No. 40 BM on headwall on the landward side. (USACE-1967). This entry matches the Drainage or Irrigation Structure referenced in O&M manual (HLM 20.27). FS Date: 04/25/2014

View of landward side.

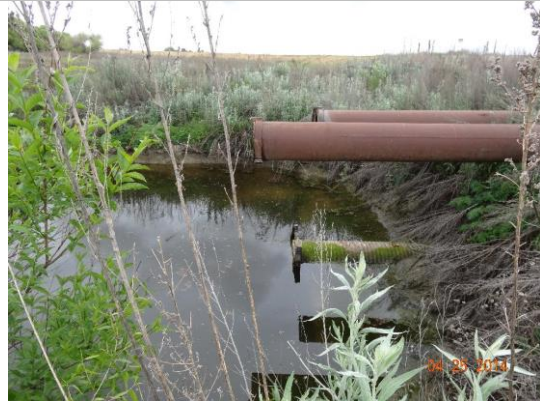
Photo 3 of 3 : UCIP_FA_2015_4916.jpg

Inspector Comments: FS_ID:39878
 DS_ID:19600
 EP_NO: N/A
 FS_HLM: 20.273
 Repair Type: Non-Urgent
 Crossing Status: Found
 UCIP Comments: Crossing partially submersed--no signs of failure of pipe present along pipe alignment. Recommend contacting owner to determine status of crossing and condition.
 FIELD_STRUCT_DESC: 36-inch CM pipe through the levee, 10.5 feet below the crown. Flap gate on the waterward end. Brass cap No. 40 BM on headwall on the landward side. (USACE-1967). This entry matches the Drainage or Irrigation Structure referenced in O&M manual (HLM 20.27).
 FS Date: 04/25/2014

Multiple crossings visible on waterward side--36 inch CMP is submersed in water.

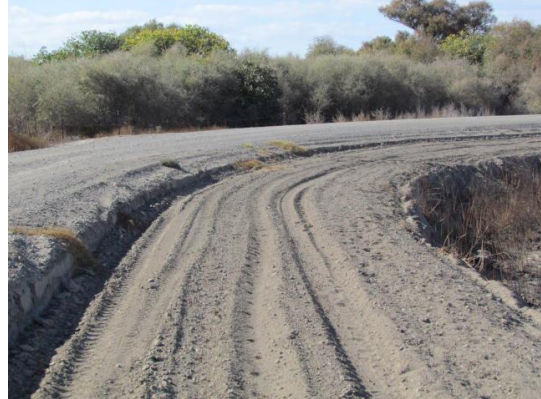
Photo 1 of 2 : FA_2015_NA0010_118_20_20150914_00013.jpg

LM Start	20.28	Rating **	U	Issue No.	20
LM End	22.01	Issue Type +	En	Location *	LS
Category	Earthen Levee			GPS Latitude/Longitude	
				Start	End
Item	Encroachments			37.193426 °	37.172663 °
				-120.760419 °	-120.754894 °
DWR ID	DWR_NA0010_01_f_2012_20				
Action/Comments					
Agricultural tilling					
Inspector Comments: Farmer cutting into landside toe and slope.

Looking east at farmer discing into landside slope.

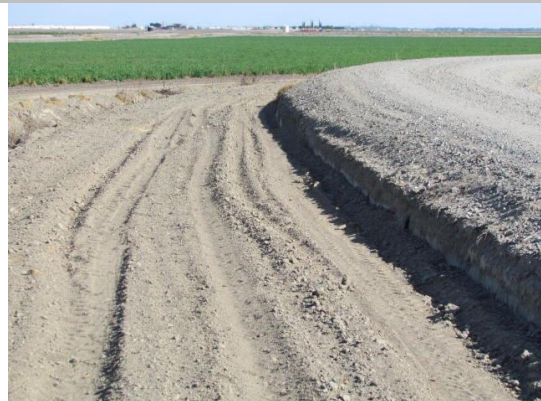
Photo 2 of 2 : FA_2015_NA0010_118_20_20150914_00014.jpg

Looking west at farmer discing landside slope.

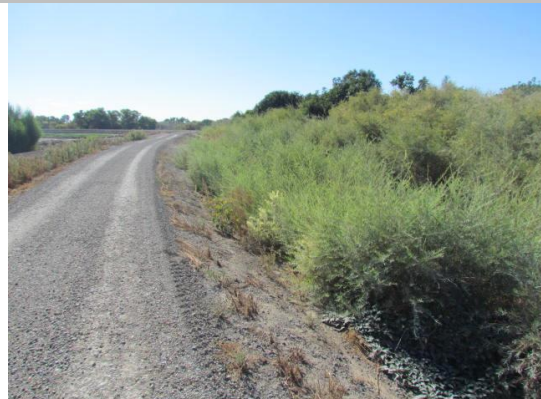
Photo 1 of 1 : FA_2015_NA0010_118_8_20151012_00036.jpg

LM Start	21.32	Rating **	U	Issue No.	8
LM End	21.35	Issue Type +	Ma	Location *	WS
Category	Earthen Levee			GPS Latitude/Longitude	
				Start	End
Item	Vegetation			37.180109 °	37.179711 °
				-120.762154 °	-120.761884 °
DWR ID	DWR_NA0010_01_f_2015_8				
Action/Comments					
Remove the wild growth other than native grasses from the levee slopes.					
Inspector Comments: Dense vegetation on waterward slope.

Looking at dense vegetation on waterward slope.

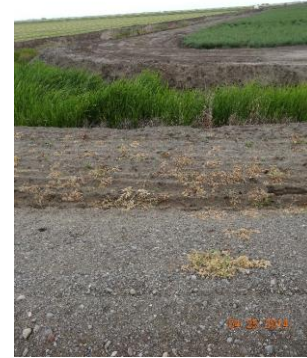
Photo 1 of 3 : UCIP_FA_2015_4917.jpg

View of landward side.

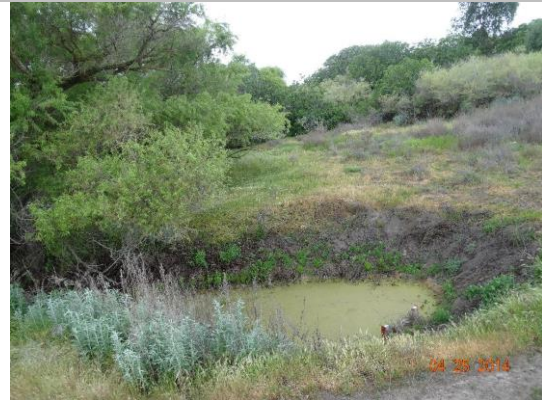
Photo 2 of 3 : UCIP_FA_2015_4918.jpg

View of waterward side.

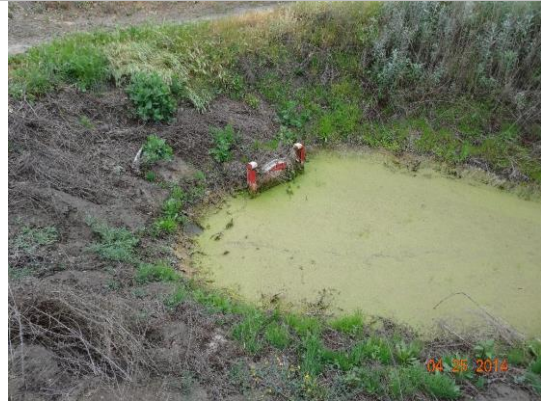
Photo 3 of 3 : UCIP_FA_2015_4919.jpg

Flap gate half way submersed located on waterward side.

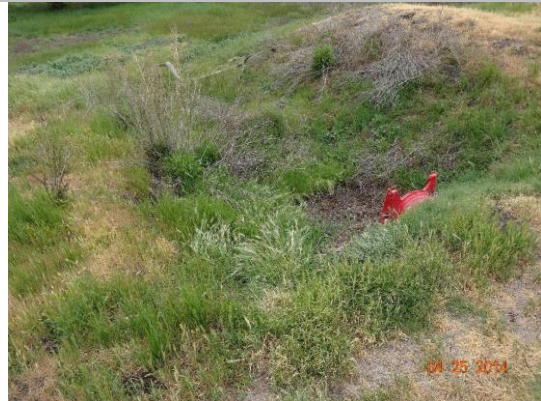
Photo 1 of 3 : UCIP_FA_2015_5493.jpg

Flap gate visible on waterward side.

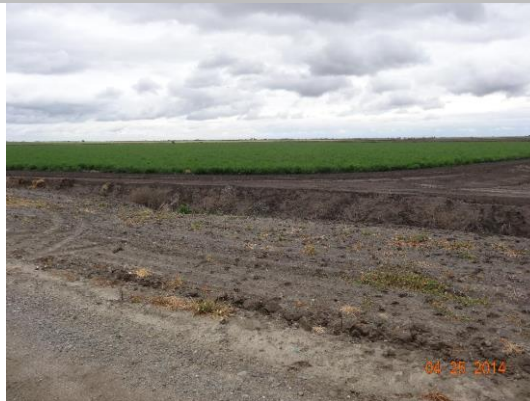
Photo 2 of 3 : UCIP_FA_2015_5599.jpg

View of landward side.

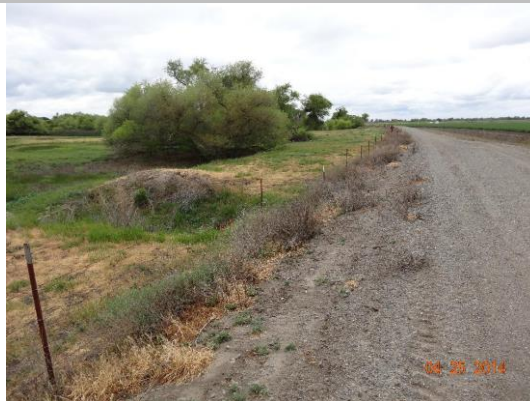
Photo 3 of 3 : UCIP_FA_2015_5600.jpg

View of waterward side.

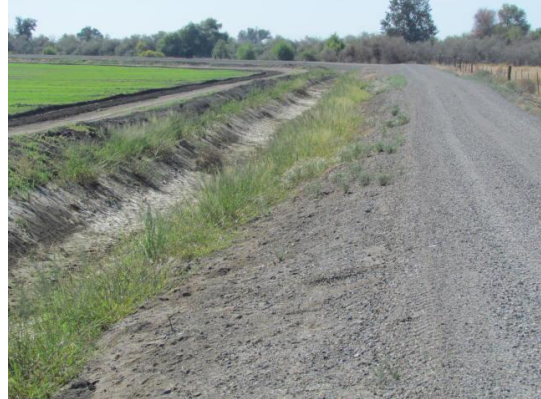
Photo 1 of 3 : FA_2015_NA0010_118_22_20151012_00037.jpg

Looking downstream at irrigation ditch at LM 22.06

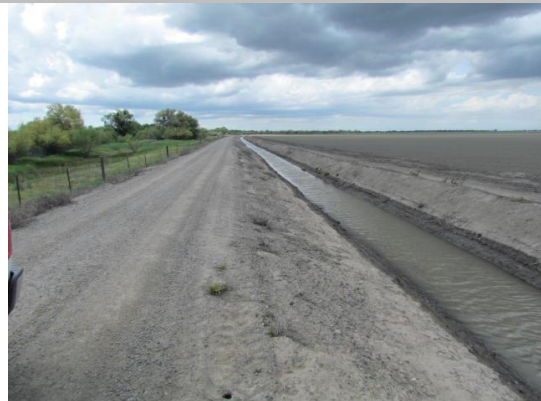
Photo 2 of 3 : FA_2015_NA0010_118_22_20150914_00015.jpg

Looking downstream at irrigation ditch at landside toe.

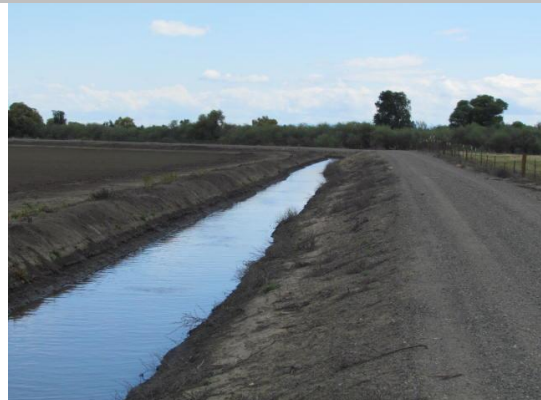
Photo 3 of 3 : FA_2015_NA0010_118_22_20150914_00016.jpg

Looking upstream at irrigation at landside toe.

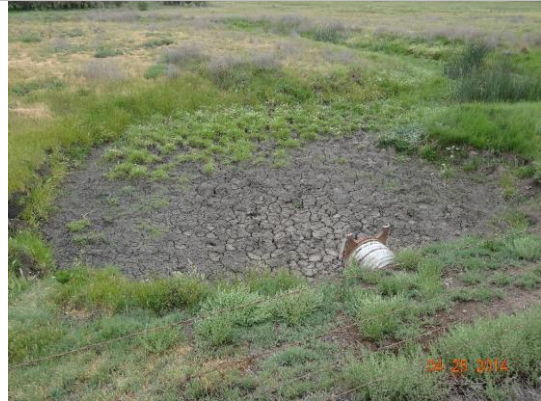
Photo 1 of 3 : UCIP_FA_2015_5601.jpg

Flap gate visible on waterward side.

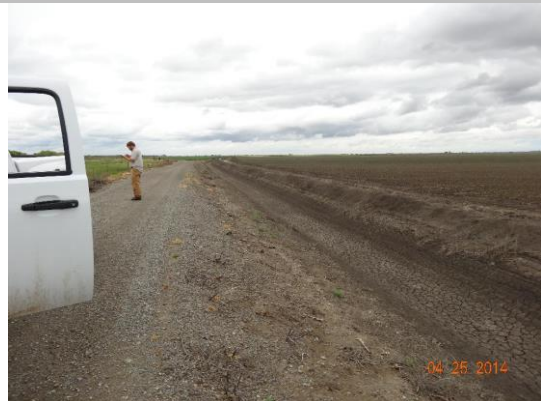
Photo 2 of 3 : UCIP_FA_2015_5602.jpg

View of landward side.

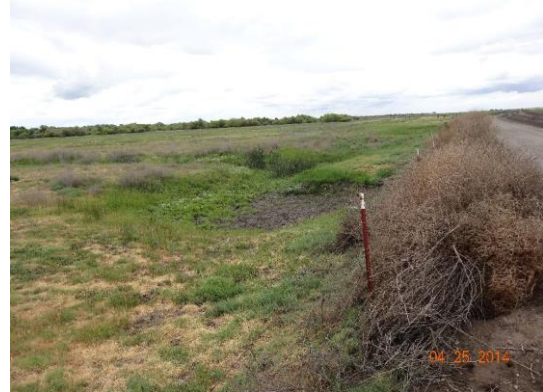
Photo 3 of 3 : UCIP_FA_2015_5603.jpg

View of waterward side.

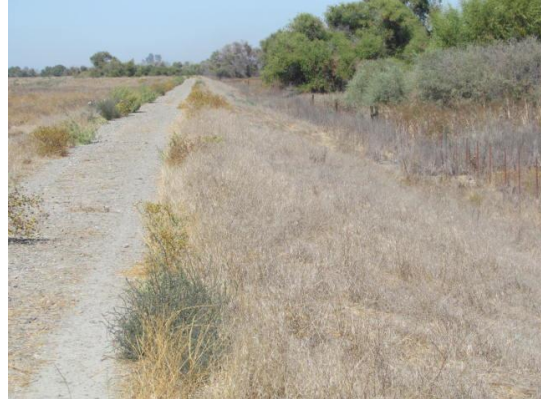
Photo 1 of 1 : FA_2015_NA0010_119_27_20151012_00007.jpg

LM Start	0.00	Rating **	M	Issue No.	27
LM End	2.30	Issue Type +	Ma	Location *	LS
Category	Earthen Levee			GPS Latitude/Longitude	
				Start	End
Item	Vegetation			37.296305 °	
				-120.880567 °	
DWR ID	DWR_NA0010_02A_f_2015_27				
Action/Comments					
Remove the wild growth other than native grasses from the levee slopes.

Looking at typical view of landward slope.

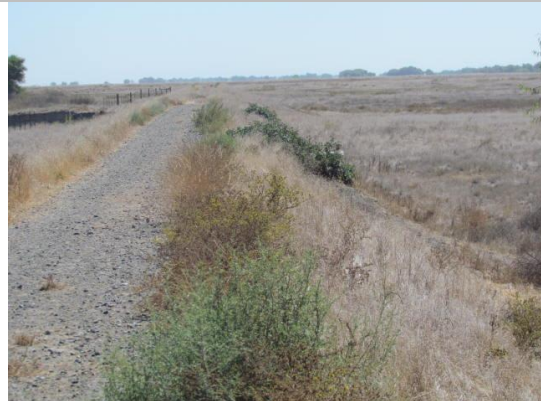
Photo 1 of 1 : FA_2015_NA0010_119_28_20151012_00008.jpg

LM Start	0.00	Rating **	M	Issue No.	28
LM End	2.30	Issue Type +	Ma	Location *	WS
Category	Earthen Levee			GPS Latitude/Longitude	
				Start	End
Item	Vegetation			37.296305 °	°
				-120.880567 °	°
DWR ID	DWR_NA0010_02A_f_2015_28				
Action/Comments					
Remove the wild growth other than native grasses from the levee slopes.

Looking at typical view of waterward slope.

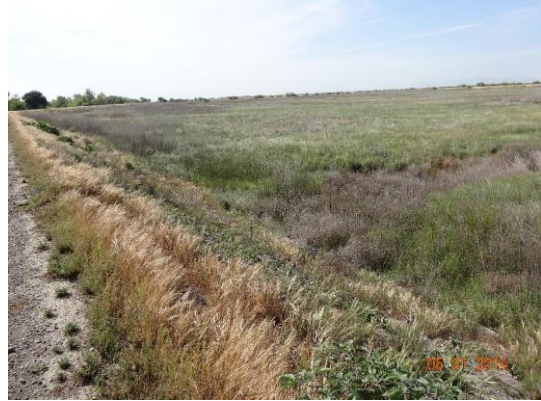
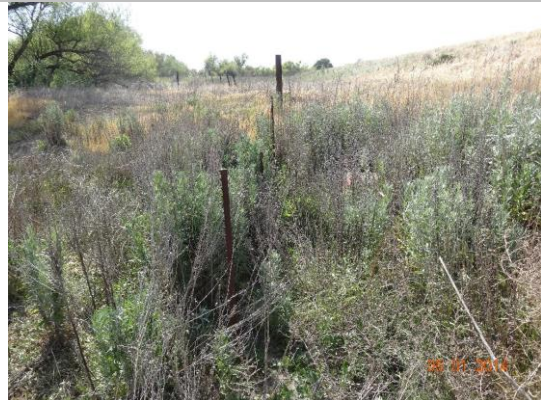
LM Start	0.23	Rating **	M	Issue No.	265
LM End	0.23	Issue Type +	En	Location *	WS
Category	Supplemental			GPS Latitude/Longitude	
				Start	End
Item	DWR UCIP Field Study			37.293440 °	37.293440 °
				-120.878978 °	-120.878978 °
DWR ID					
Action/Comments					
Inspector Comments: FS_ID:36503 DS_ID:19652 EP_NO: N/A FS_HLM: 0.24 Repair Type: Non-Urgent Crossing Status: Found UCIP Comments: Dense vegetation limits the inspector's visibility to identify signs of pipe failure (leaks) along the slope. Recommend removing vegetation along pipe alignment to conduct proper inspection of structure. FIELD_STRUCT_DESC: 24-inch CM pipe through the levee, 11.0 feet below the crown. Flap gate on the waterward end. Brass cap No. 139 BM on headwall on the landward side. (USACE-1967). This entry matches the Drainage or Irrigation Structure referenced in O&M manual (HLM 0.24). FS Date: 05/01/2014

View of landward side.

Fence along waterward side. No headwall was found on waterward side.

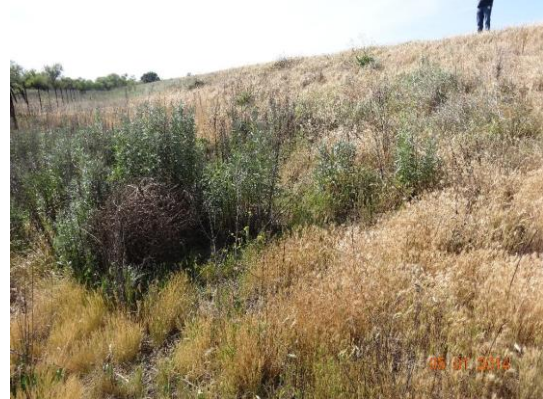
Photo 3 of 3 : UCIP_FA_2015_5679.jpg

LM Start	0.23	Rating **	M	Issue No.	265 (cont)
LM End	0.23	Issue Type +	En	Location *	WS
Category	Supplemental			GPS Latitude/Longitude	
				Start	End
Item	DWR UCIP Field Study			37.293440 °	37.293440 °
				-120.878978 °	-120.878978 °
DWR ID					
Action/Comments					
Inspector Comments: FS_ID:36503					
DS_ID:19652					
EP_NO: N/A					
FS_HLM: 0.24					
Repair Type: Non-Urgent					
Crossing Status: Found

View of waterward side.

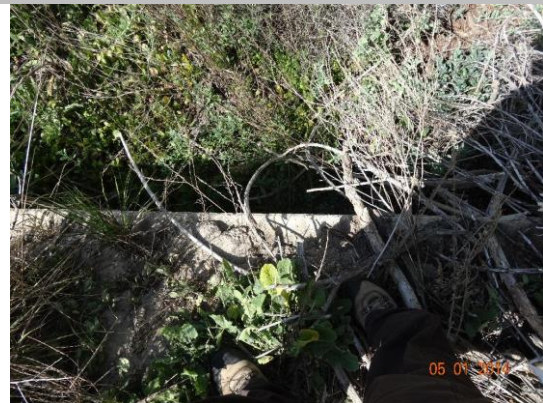
Photo 1 of 3 : UCIP_FA_2015_5680.jpg

LM Start	0.66	Rating **	M	Issue No.	266
LM End	0.66	Issue Type +	En	Location *	WS
Category	Supplemental			GPS Latitude/Longitude	
				Start	End
Item	DWR UCIP Field Study			37.288087 °	37.288087 °
				-120.874919 °	-120.874919 °
DWR ID					
Action/Comments					
Inspector Comments: FS_ID:36504 DS_ID:19653 EP_NO: N/A FS_HLM: 0.67 Repair Type: Non-Urgent Crossing Status: Found UCIP Comments: Dense vegetation limits the inspector's visibility to identify signs of pipe failure (leaks) along the slope. Recommend removing vegetation along pipe alignment to conduct proper inspection of structure. FIELD_STRUCT_DESC: 24-inch CM pipe through the levee, 14.8 feet below the crown. Flap gate on the waterward end. Brass cap No. 138 BM on headwall on the landward side. (USACE-1967). This entry matches the Drainage or Irrigation Structure referenced in O&M manual (HLM 0.67). FS Date: 05/01/2014

Concrete headwall found on landward side.

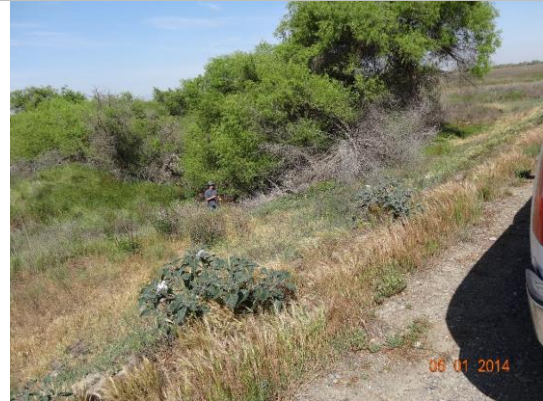
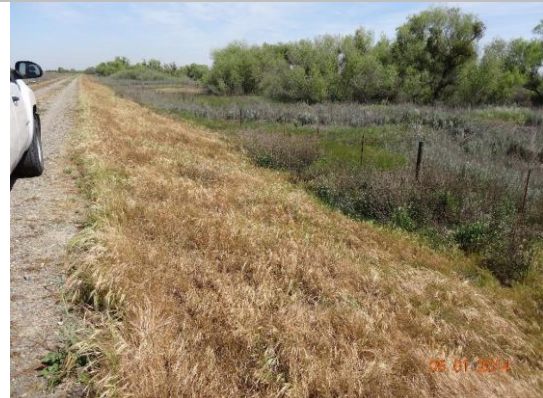
LM Start	0.66	Rating **	M	Issue No.	266 (cont)
LM End	0.66	Issue Type +	En	Location *	WS
Category	Supplemental			GPS Latitude/Longitude	
				Start	End
Item	DWR UCIP Field Study			37.288087 °	37.288087 °
				-120.874919 °	-120.874919 °
DWR ID					
Action/Comments					
Inspector Comments: FS_ID:36504 DS_ID:19653 EP_NO: N/A FS_HLM: 0.67 Repair Type: Non-Urgent Crossing Status: Found UCIP Comments: Dense vegetation limits the inspector's visibility to identify signs of pipe failure (leaks) along the slope. Recommend removing vegetation along pipe alignment to conduct proper inspection of structure. FIELD_STRUCT_DESC: 24-inch CM pipe through the levee, 14.8 feet below the crown. Flap gate on the waterward end. Brass cap No. 138 BM on headwall on the landward side. (USACE-1967). This entry matches the Drainage or Irrigation Structure referenced in O&M manual (HLM 0.67). FS Date: 05/01/2014

View of landward side.

View of waterward side.

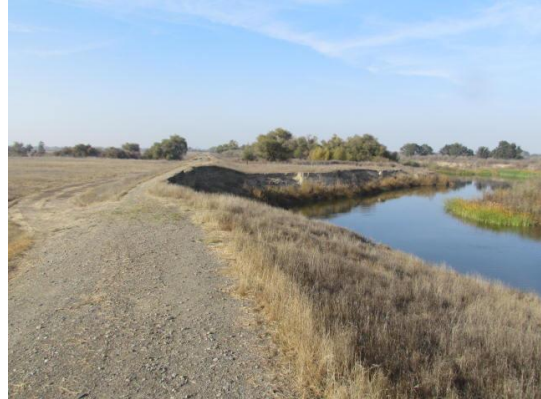
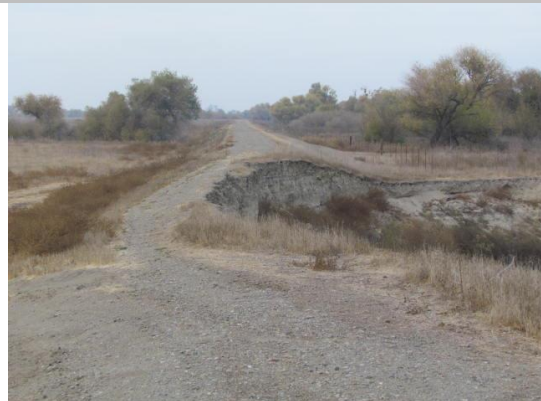
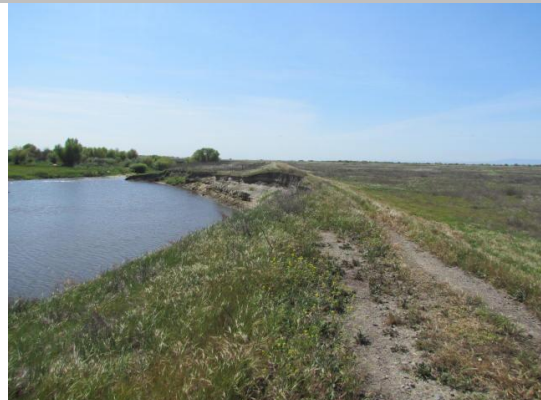
LM Start	0.75	Rating **	U	Issue No.	5
LM End	0.75	Issue Type +	Ma	Location *	WS
Category	Earthen Levee			GPS Latitude/Longitude	
				Start	End
Item	Erosion / Bank Caving			37.286877 °	37.286877 °
				-120.874222 °	-120.874222 °
DWR ID	DWR_NA0010_02A_s _ 2012_5				
Action/Comments					
Schedule repair of erosion site prior to the next inspection. Inspector Comments: A field investigation report in on file. For more information and pictures see field investigation report #4301.

Looking north at erosion on waterward slope. (Fall 2014)

Looking north at large erosion on waterward slope. (Fall 2013)

Looking south at large erosion on waterside slope. (Spring 2012)

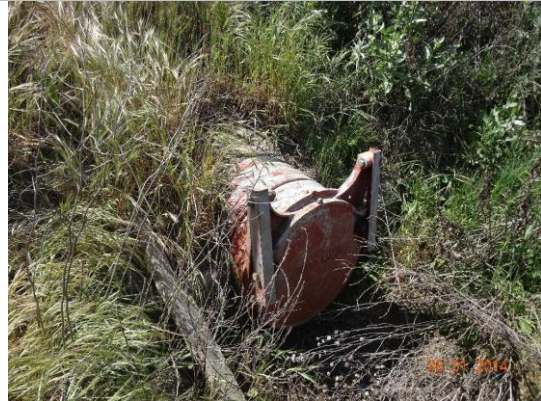
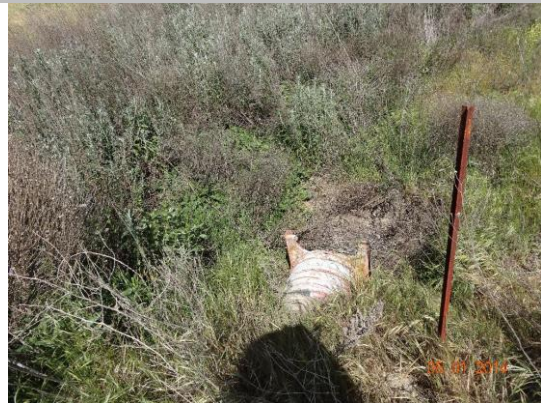
LM Start	1.01	Rating **	M	Issue No.	267
LM End	1.01	Issue Type +	En	Location *	WS
Category	Supplemental			GPS Latitude/Longitude	
				Start	End
Item	DWR UCIP Field Study			37.284889 °	37.284889 °
				-120.871352 °	-120.871352 °
DWR ID					
Action/Comments					
Inspector Comments: FS_ID:39363					
DS_ID:19654					
EP_NO: N/A					
FS_HLM: 1.02					
Repair Type: Non-Urgent					
Crossing Status: Found

Flap gate visible on waterward side.

Pipe visible on waterward side.

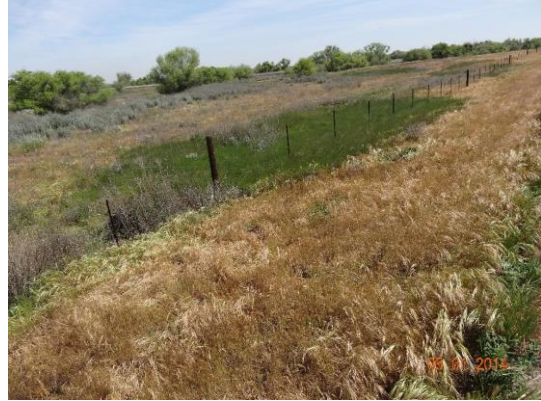
Photo 3 of 3 : UCIP_FA_2015_5685.jpg

LM Start	1.01	Rating **	M	Issue No.	267 (cont)
LM End	1.01	Issue Type +	En	Location *	WS
Category	Supplemental			GPS Latitude/Longitude	
				Start	End
Item	DWR UCIP Field Study			37.284889 °	37.284889 °
				-120.871352 °	-120.871352 °
DWR ID					
Action/Comments					
Inspector Comments: FS_ID:39363					
DS_ID:19654					
EP_NO: N/A					
FS_HLM: 1.02					
Repair Type: Non-Urgent					
Crossing Status: Found

View of waterward side.
