**Flood Control Project Maintenance
Levee Inspections**

Fall 2015 Levee Maintenance Deficiency Summary Report

San Joaquin River Basin

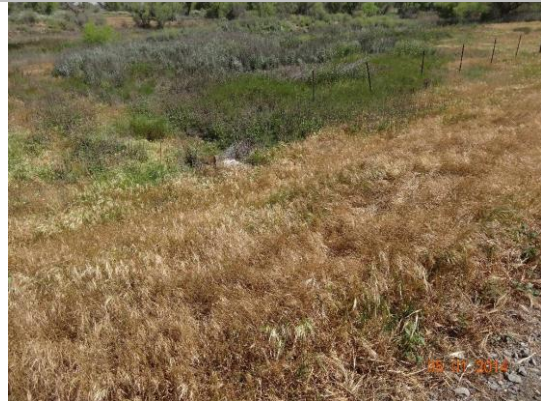
Photo 1 of 3 : UCIP_FA_2015_5686.jpg

LM Start	1.21	Rating **	M	Issue No.	268
LM End	1.21	Issue Type +	En	Location *	WS
Category	Supplemental			GPS Latitude/Longitude	
				Start	End
Item	DWR UCIP Field Study			37.286118 °	37.286118 °
				-120.868167 °	-120.868167 °
DWR ID					
Action/Comments					
Inspector Comments: FS_ID:36506 DS_ID:19655 EP_NO: N/A FS_HLM: 1.22 Repair Type: Non-Urgent Crossing Status: Found UCIP Comments: Dense vegetation limits the inspector's visibility to identify signs of pipe failure (leaks) along the slope. Recommend removing vegetation along pipe alignment to conduct proper inspection of structure. FIELD_STRUCT_DESC: 24-inch CM pipe through the levee, 8.6 feet below the crown. Flap gate on the waterward end. Brass cap No. 136 BM on headwall on the landward side. (USACE-1967). This entry matches the Drainage or Irrigation Structure referenced in O&M manual (HLM 1.22). FS Date: 05/01/2014

Overview of waterward side.

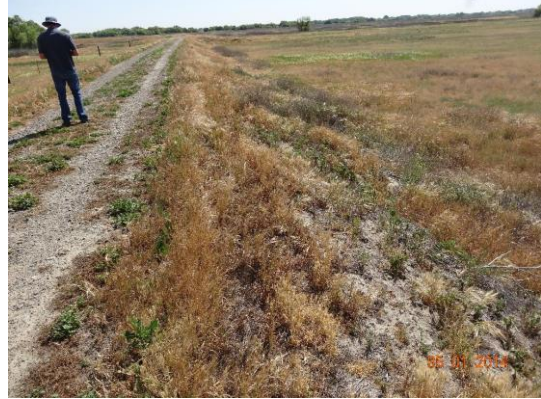
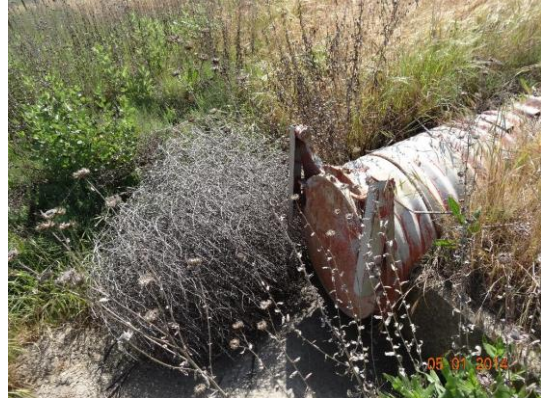
Item	DWR UCIP Field Study			37.286118 °	37.286118 °	
				-120.868167 °	-120.868167 °	
DWR ID						
Action/Comments						
Inspector Comments: FS_ID:36506 DS_ID:19655 EP_NO: N/A FS_HLM: 1.22 Repair Type: Non-Urgent Crossing Status: Found UCIP Comments: Dense vegetation limits the inspector's visibility to identify signs of pipe failure (leaks) along the slope. Recommend removing vegetation along pipe alignment to conduct proper inspection of structure. FIELD_STRUCT_DESC: 24-inch CM pipe through the levee, 8.6 feet below the crown. Flap gate on the waterward end. Brass cap No. 136 BM on headwall on the landward side. (USACE-1967). This entry matches the Drainage or Irrigation Structure referenced in O&M manual (HLM 1.22). FS Date: 05/01/2014

View of landward side.

Flap gate visible on waterward side.

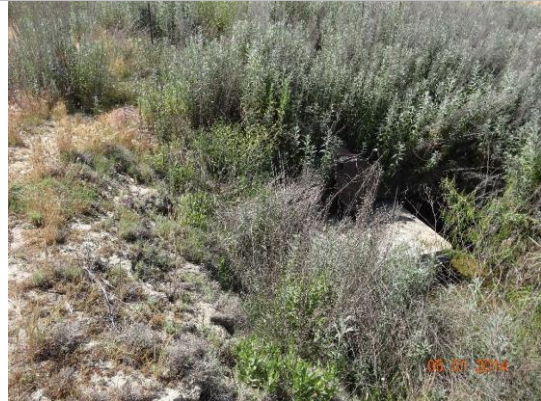
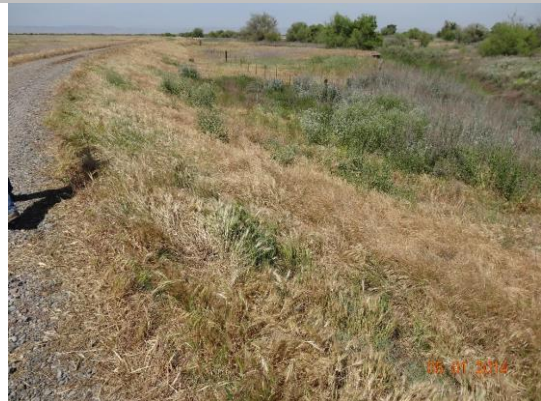
LM Start	1.33	Rating **	M	Issue No.	269
LM End	1.33	Issue Type +	En	Location *	WS
Category	Supplemental			GPS Latitude/Longitude	
				Start	End
Item	DWR UCIP Field Study			37.286463 °	37.286463 °
				-120.865997 °	-120.865997 °
DWR ID					
Action/Comments					
Inspector Comments: FS_ID:36507					
DS_ID:19656					
EP_NO: N/A					
FS_HLM: 1.34					
Repair Type: Non-Urgent					
Crossing Status: Found

Flap gate and concrete apron visible on waterward side.

View of waterward side.

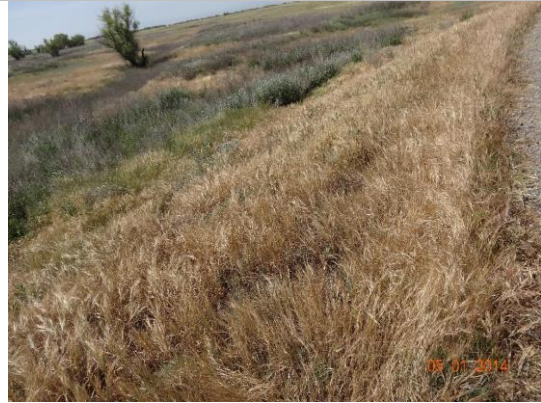
Photo 3 of 3 : UCIP_FA_2015_5711.jpg

LM Start	1.33	Rating **	M	Issue No.	269 (cont)
LM End	1.33	Issue Type +	En	Location *	WS
Category	Supplemental			GPS Latitude/Longitude	
				Start	End
Item	DWR UCIP Field Study			37.286463 °	37.286463 °
				-120.865997 °	-120.865997 °
DWR ID					
Action/Comments					
Inspector Comments: FS_ID:36507 DS_ID:19656 EP_NO: N/A FS_HLM: 1.34 Repair Type: Non-Urgent Crossing Status: Found

View of landward side.

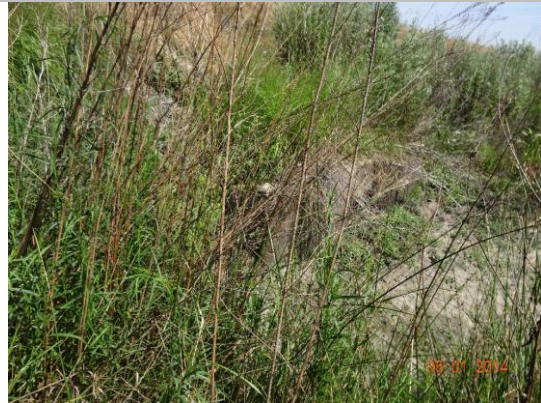
Photo 1 of 3 : UCIP_FA_2015_5712.jpg

LM Start	1.61	Rating **	M	Issue No.	270
LM End	1.61	Issue Type +	En	Location *	WS
Category	Supplemental			GPS Latitude/Longitude	
				Start	End
Item	DWR UCIP Field Study			37.288599 °	37.288599 °
				-120.862007 °	-120.862007 °
DWR ID					
Action/Comments					
Inspector Comments: FS_ID:36508 DS_ID:19657 EP_NO: N/A FS_HLM: 1.62 Repair Type: Non-Urgent Crossing Status: Found UCIP Comments: Dense vegetation limits the inspector's visibility to identify signs of pipe failure (leaks) along the slope. Recommend removing vegetation along pipe alignment to conduct proper inspection of structure. FIELD_STRUCT_DESC: 24-inch CM pipe through the levee, 10.2 feet below the crown. Flap gate on the waterward end. Brass cap No. 135 BM on headwall on the landward side. (USACE-1967). This entry matches the Drainage or Irrigation Structure referenced in O&M manual (HLM 1.62). FS Date: 05/01/2014

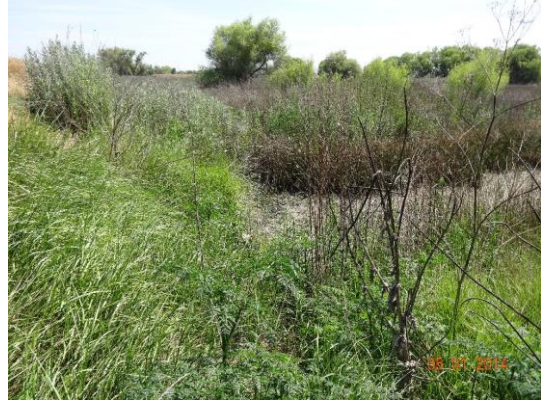
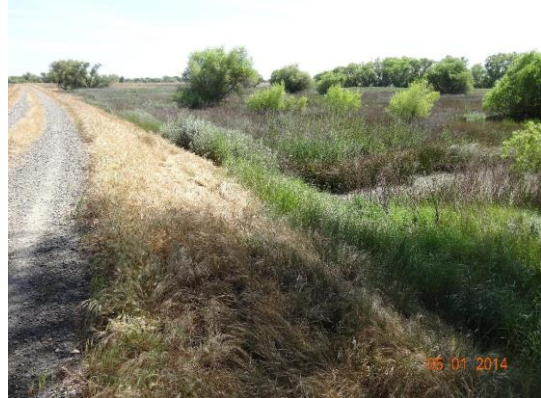
LM Start	1.61	Rating **	M	Issue No.	270 (cont)
LM End	1.61	Issue Type +	En	Location *	WS
Category	Supplemental			GPS Latitude/Longitude	
				Start	End
Item	DWR UCIP Field Study			37.288599 °	37.288599 °
				-120.862007 °	-120.862007 °
DWR ID					
Action/Comments					
Inspector Comments: FS_ID:36508 DS_ID:19657 EP_NO: N/A FS_HLM: 1.62 Repair Type: Non-Urgent Crossing Status: Found UCIP Comments: Dense vegetation limits the inspector's visibility to identify signs of pipe failure (leaks) along the slope. Recommend removing vegetation along pipe alignment to conduct proper inspection of structure. FIELD_STRUCT_DESC: 24-inch CM pipe through the levee, 10.2 feet below the crown. Flap gate on the waterward end. Brass cap No. 135 BM on headwall on the landward side. (USACE-1967). This entry matches the Drainage or Irrigation Structure referenced in O&M manual (HLM 1.62). FS Date: 05/01/2014

Dense vegetation along levee slope and toe.

Overview of landward side.

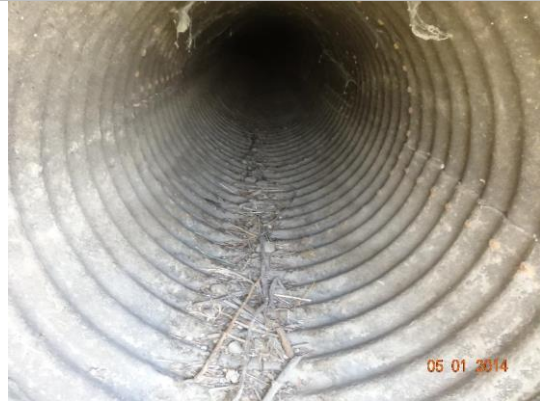
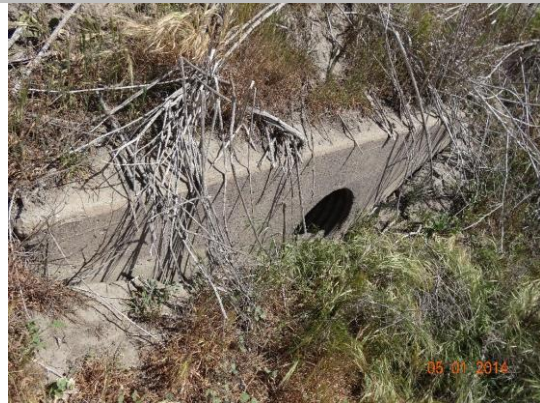
LM Start	1.85	Rating **	M	Issue No.	271
LM End	1.85	Issue Type +	En	Location *	WS
Category	Supplemental			GPS Latitude/Longitude	
				Start	End
Item	DWR UCIP Field Study			37.290836 °	37.290836 °
				-120.858882 °	-120.858882 °
DWR ID					
Action/Comments					
Inspector Comments: FS_ID:36509 DS_ID:19658 EP_NO: N/A FS_HLM: 1.86 Repair Type: Non-Urgent Crossing Status: Found

Inside view of pipe from landward side.

Concrete headwall visible on landward side.

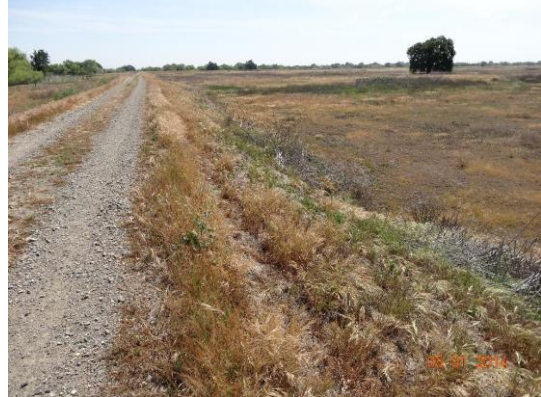
Photo 3 of 3 : UCIP_FA_2015_5717.jpg

LM Start	1.85	Rating **	M	Issue No.	271 (cont)
LM End	1.85	Issue Type +	En	Location *	WS
Category	Supplemental			GPS Latitude/Longitude	
				Start	End
Item	DWR UCIP Field Study			37.290836 °	37.290836 °
				-120.858882 °	-120.858882 °
DWR ID					
Action/Comments					
Inspector Comments: FS_ID:36509 DS_ID:19658 EP_NO: N/A FS_HLM: 1.86 Repair Type: Non-Urgent Crossing Status: Found

View of landward side.

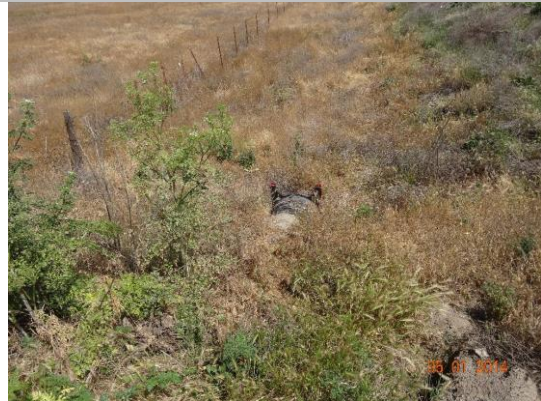
Photo 1 of 3 : UCIP_FA_2015_5718.jpg

LM Start	2.28	Rating **	M	Issue No.	272
LM End	2.28	Issue Type +	En	Location *	WS
Category	Supplemental			GPS Latitude/Longitude	
				Start	End
Item	DWR UCIP Field Study			37.291686 °	37.291686 °
				-120.851475 °	-120.851475 °
DWR ID					
Action/Comments					
Inspector Comments: FS_ID:36510 DS_ID:19659 EP_NO: N/A FS_HLM: 2.3 Repair Type: Non-Urgent Crossing Status: Found UCIP Comments: Dense vegetation limits the inspector's visibility to identify signs of pipe failure (leaks) along the slope. Recommend removing vegetation along pipe alignment to conduct proper inspection of structure. FIELD_STRUCT_DESC: 24-inch CM pipe through the levee, 7.0 feet below the crown. Flap gate on the waterward end. Brass cap No. 135 BM on headwall on the landward side. (USACE-1967). This entry matches the Drainage or Irrigation Structure referenced in O&M manual (HLM 2.30). FS Date: 05/01/2014

View of pipe through levee visible on waterward side.

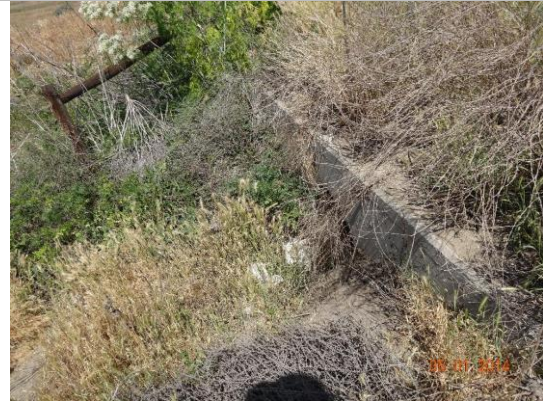
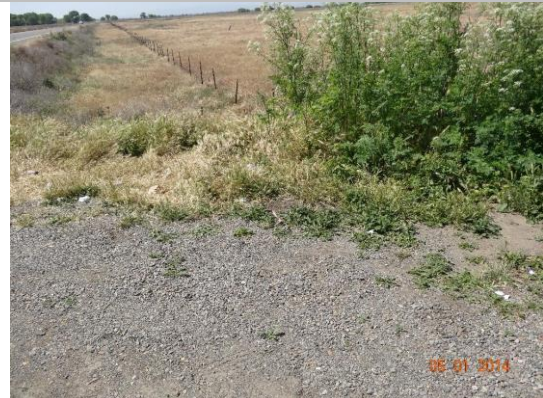
LM Start	2.28	Rating **	M	Issue No.	272 (cont)
LM End	2.28	Issue Type +	En	Location *	WS
Category	Supplemental			GPS Latitude/Longitude	
				Start	End
Item	DWR UCIP Field Study			37.291686 °	37.291686 °
				-120.851475 °	-120.851475 °
DWR ID					
Action/Comments					
Inspector Comments: FS_ID:36510 DS_ID:19659 EP_NO: N/A FS_HLM: 2.3 Repair Type: Non-Urgent Crossing Status: Found UCIP Comments: Dense vegetation limits the inspector's visibility to identify signs of pipe failure (leaks) along the slope. Recommend removing vegetation along pipe alignment to conduct proper inspection of structure. FIELD_STRUCT_DESC: 24-inch CM pipe through the levee, 7.0 feet below the crown. Flap gate on the waterward end. Brass cap No. 135 BM on headwall on the landward side. (USACE-1967). This entry matches the Drainage or Irrigation Structure referenced in O&M manual (HLM 2.30). FS Date: 05/01/2014

Concrete headwall visible on landward side.

View of landward side.

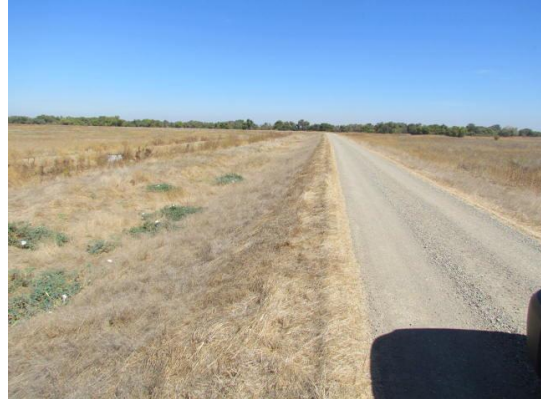
Photo 1 of 1 : FA_2015_NA0010_119_25_20151012_00009.jpg

LM Start	2.30	Rating **	A	Issue No.	25
LM End	8.87	Issue Type +	Ma	Location *	LS
Category	Earthen Levee			GPS Latitude/Longitude	
				Start	End
Item	Vegetation				o
					o
DWR ID	DWR_NA0010_02A_f_2015_25				
Action/Comments					
Remove the wild growth other than native grasses from the levee slopes.

Looking at typical view of landward slope.

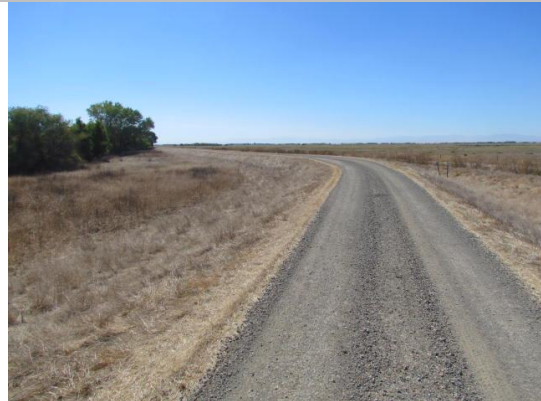
Photo 1 of 1 : FA_2015_NA0010_119_26_20151012_00010.jpg

LM Start	2.30	Rating **	A	Issue No.	26	
LM End	8.87	Issue Type +	Ma	Location *	WS	
Category	Earthen Levee			GPS Latitude/Longitude		
				Start		End
Item	Vegetation					°
						°
DWR ID	DWR_NA0010_02A_f_2015_26					
Action/Comments						
Remove the wild growth other than native grasses from the levee slopes.

Looking at typical view of waterward slope.

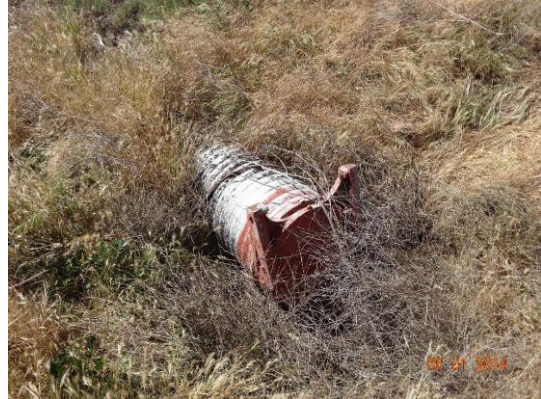
Photo 1 of 3 : UCIP_FA_2015_4931.jpg

LM Start	2.30	Rating **	M	Issue No.	273
LM End	2.30	Issue Type +	En	Location *	WS
Category	Supplemental			GPS Latitude/Longitude	
				Start	End
Item	DWR UCIP Field Study			37.291532 °	37.291532 °
				-120.851203 °	-120.851203 °
DWR ID					
Action/Comments					
Inspector Comments: FS_ID:36511 DS_ID:19660 EP_NO: N/A FS_HLM: 2.32 Repair Type: Non-Urgent Crossing Status: Found UCIP Comments: Dense vegetation limits the inspector's visibility to identify signs of pipe failure (leaks) along the slope. Recommend removing vegetation along pipe alignment to conduct proper inspection of structure. FIELD_STRUCT_DESC: 24-inch CM pipe through the levee, 7.0 feet below the crown. Flap gate on the waterward end. Brass cap No. 135 BM on headwall on the landward side. (USACE-1967). This entry matches the Drainage or Irrigation Structure referenced in O&M manual (HLM 2.32). FS Date: 05/01/2014

Flap gate visible on waterward side.

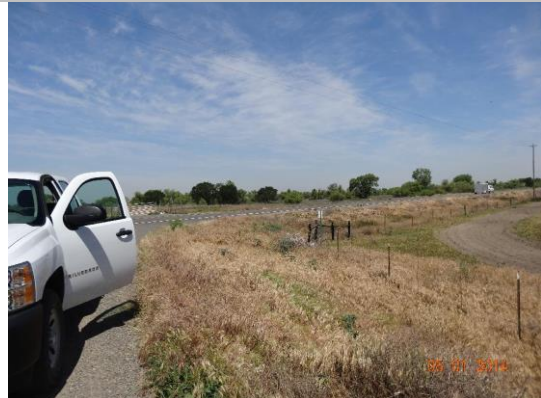
Photo 2 of 3 : UCIP_FA_2015_4932.jpg

View of waterward side.

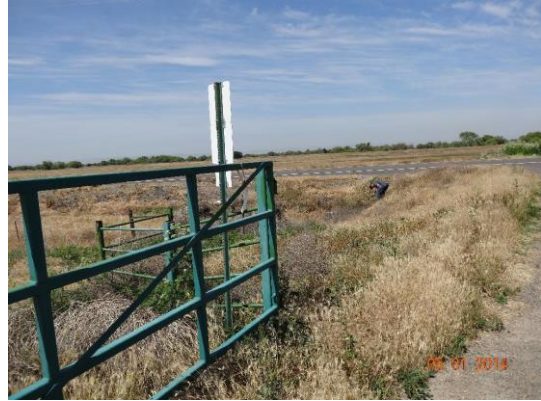
Photo 3 of 3 : UCIP_FA_2015_4933.jpg

LM Start	2.30	Rating **	M	Issue No.	273 (cont)
LM End	2.30	Issue Type +	En	Location *	WS
Category	Supplemental			GPS Latitude/Longitude	
				Start	End
Item	DWR UCIP Field Study			37.291532 °	37.291532 °
				-120.851203 °	-120.851203 °
DWR ID					
Action/Comments					
Inspector Comments: FS_ID:36511					
DS_ID:19660					
EP_NO: N/A					
FS_HLM: 2.32					
Repair Type: Non-Urgent					
Crossing Status: Found

Overview of landward slope.

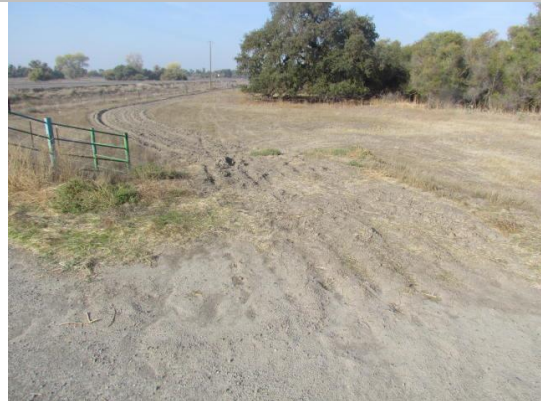
Photo 1 of 2 : FA_2015_NA0010_119_2_20150914_00001.jpg

LM Start	2.32	Rating **	M	Issue No.	2
LM End	2.32	Issue Type +	En	Location *	LS
Category	Earthen Levee			GPS Latitude/Longitude	
				Start	End
Item	Encroachments			37.291433 °	37.291433 °
				-120.850917 °	-120.850917 °
DWR ID	DWR_NA0010_02A_s_2012_2				
Action/Comments					
Ramp Inspector Comments: Unauthorized ramp on landside and waterside slope.

Looking northeast at unauthorized ramp on landward slope.

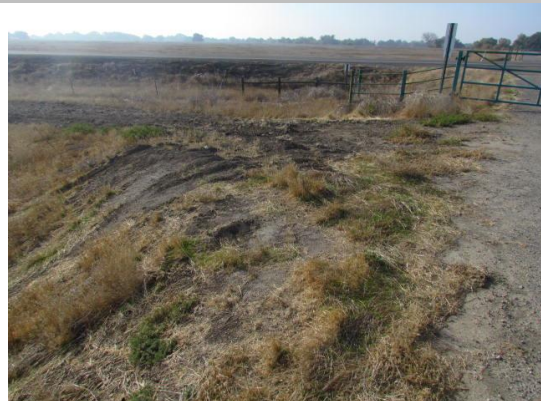
Photo 2 of 2 : FA_2015_NA0010_119_2_20150914_00002.jpg

Looking northwest at unauthorized ramp on waterward slope.

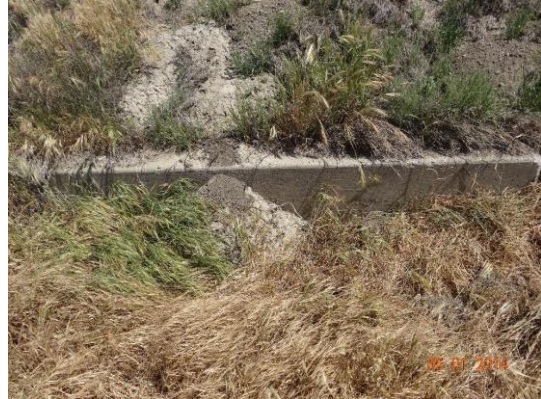
Photo 1 of 3 : UCIP_FA_2015_4934.jpg

LM Start	2.58	Rating **	M	Issue No.	274
LM End	2.58	Issue Type +	En	Location *	LS
Category	Supplemental			GPS Latitude/Longitude	
				Start	End
Item	DWR UCIP Field Study			37.289487 °	37.289487 °
				-120.846941 °	-120.846941 °
DWR ID					
Action/Comments					
Inspector Comments: FS_ID:36512 DS_ID:19661 EP_NO: N/A FS_HLM: 2.59 Repair Type: Non-Urgent Crossing Status: Found

Non-functional crossing concrete headwall and inlet buried on landward side.

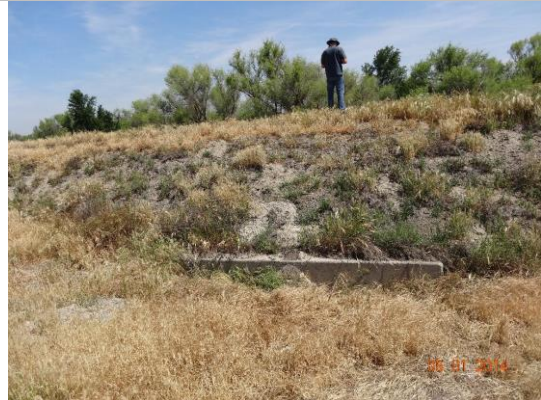
Photo 2 of 3 : UCIP_FA_2015_4935.jpg

Concrete headwall visible on landward side.

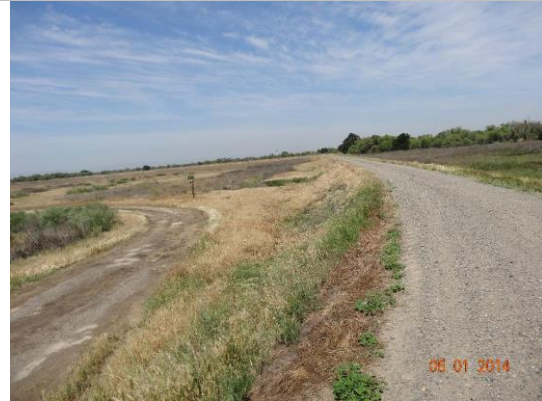
Photo 3 of 3 : UCIP_FA_2015_4936.jpg

LM Start	2.58	Rating **	M	Issue No.	274 (cont)
LM End	2.58	Issue Type +	En	Location *	LS
Category	Supplemental			GPS Latitude/Longitude	
				Start	End
Item	DWR UCIP Field Study			37.289487 °	37.289487 °
				-120.846941 °	-120.846941 °
DWR ID					
Action/Comments					
Inspector Comments: FS_ID:36512					
DS_ID:19661					
EP_NO: N/A					
FS_HLM: 2.59					
Repair Type: Non-Urgent					
Crossing Status: Found

View of landward side.

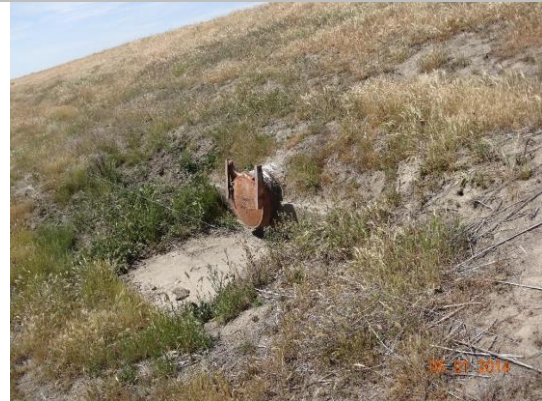
Photo 1 of 2 : UCIP_FA_2015_4937.jpg

LM Start	2.95	Rating **	M	Issue No.	275
LM End	2.95	Issue Type +	En	Location *	LS
Category	Supplemental			GPS Latitude/Longitude	
				Start	End
Item	DWR UCIP Field Study			37.284326 °	37.284326 °
				-120.845157 °	-120.845157 °
DWR ID					
Action/Comments					
Inspector Comments: FS_ID:36513 DS_ID:19662 EP_NO: N/A FS_HLM: 2.96 Repair Type: Non-Urgent Crossing Status: Found UCIP Comments: Dense vegetation limits the inspector's visibility to identify signs of pipe failure (leaks) along the slope. Recommend removing vegetation along pipe alignment to conduct proper inspection of structure. FIELD_STRUCT_DESC: 24-inch CM pipe through the levee, 10.0 feet below the crown. Flap gate on the waterward end. Brass cap No. 130 BM on headwall on the landward side. (USACE-1967). This entry matches the Drainage or Irrigation Structure referenced in O&M manual (HLM 2.96). FS Date: 05/01/2014

Flap gate visible on waterward side.

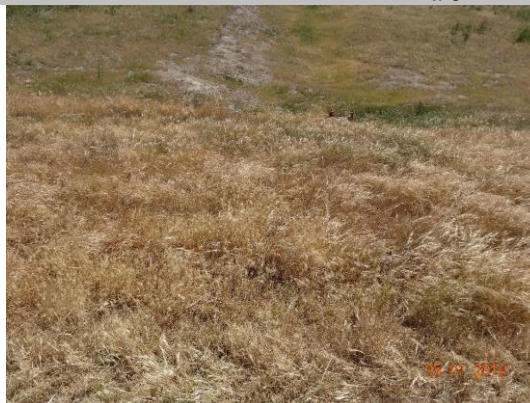
Photo 2 of 2 : UCIP_FA_2015_4938.jpg

Item	DWR UCIP Field Study			37.284326 °	37.284326 °	
				-120.845157 °	-120.845157 °	
DWR ID						
Action/Comments						
Inspector Comments: FS_ID:36513 DS_ID:19662 EP_NO: N/A FS_HLM: 2.96 Repair Type: Non-Urgent Crossing Status: Found UCIP Comments: Dense vegetation limits the inspector's visibility to identify signs of pipe failure (leaks) along the slope. Recommend removing vegetation along pipe alignment to conduct proper inspection of structure. FIELD_STRUCT_DESC: 24-inch CM pipe through the levee, 10.0 feet below the crown. Flap gate on the waterward end. Brass cap No. 130 BM on headwall on the landward side. (USACE-1967). This entry matches the Drainage or Irrigation Structure referenced in O&M manual (HLM 2.96). FS Date: 05/01/2014

View of waterward side.

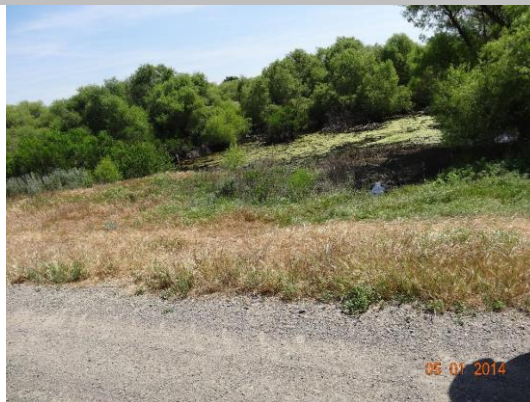
Photo 1 of 3 : UCIP_FA_2015_5030.jpg

LM Start	3.28	Rating **	M	Issue No.	276
LM End	3.28	Issue Type +	En	Location *	LS
Category	Supplemental			GPS Latitude/Longitude	
				Start	End
Item	DWR UCIP Field Study			37.279656 °	37.279656 °
				-120.844795 °	-120.844795 °
DWR ID					
Action/Comments					
Inspector Comments: FS_ID:36514 DS_ID:19665 EP_NO: N/A FS_HLM: 3.29 Repair Type: Non-Urgent Crossing Status: Found UCIP Comments: Dense vegetation limits the inspector's visibility to identify signs of pipe failure (leaks) along the slope. Recommend removing vegetation along pipe alignment to conduct proper inspection of structure. FIELD_STRUCT_DESC: 24-inch CM pipe through the levee, 12.4 feet below the crown. Flap gate on the waterward end. Brass cap No. 130 BM on headwall on the landward side. (USACE-1967). This entry matches the Drainage or Irrigation Structure referenced in O&M manual (HLM 3.29). FS Date: 05/01/2014

View of waterward side.

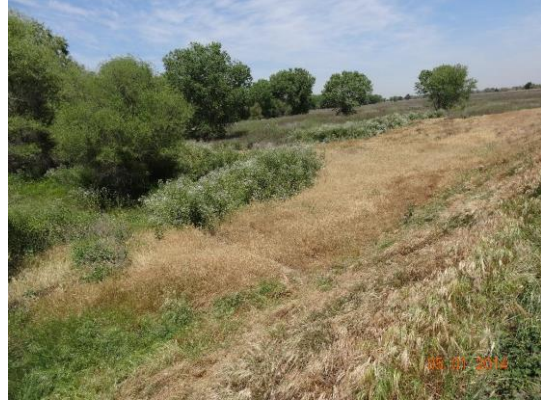
Photo 2 of 3 : UCIP_FA_2015_5031.jpg

LM Start	3.28	Rating **	M	Issue No.	276 (cont)
LM End	3.28	Issue Type +	En	Location *	LS
Category	Supplemental			GPS Latitude/Longitude	
				Start	End
Item	DWR UCIP Field Study			37.279656 °	37.279656 °
				-120.844795 °	-120.844795 °
DWR ID					
Action/Comments					
Inspector Comments: FS_ID:36514 DS_ID:19665 EP_NO: N/A FS_HLM: 3.29 Repair Type: Non-Urgent Crossing Status: Found UCIP Comments: Dense vegetation limits the inspector's visibility to identify signs of pipe failure (leaks) along the slope. Recommend removing vegetation along pipe alignment to conduct proper inspection of structure. FIELD_STRUCT_DESC: 24-inch CM pipe through the levee, 12.4 feet below the crown. Flap gate on the waterward end. Brass cap No. 130 BM on headwall on the landward side. (USACE-1967). This entry matches the Drainage or Irrigation Structure referenced in O&M manual (HLM 3.29). FS Date: 05/01/2014

View of landward side.

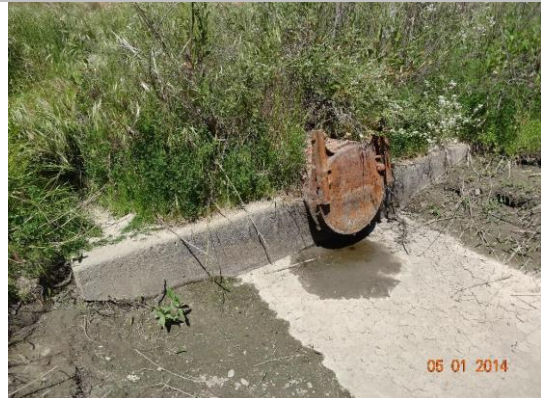
Photo 3 of 3 : UCIP_FA_2015_5032.jpg

Flap gate visible on waterward side.

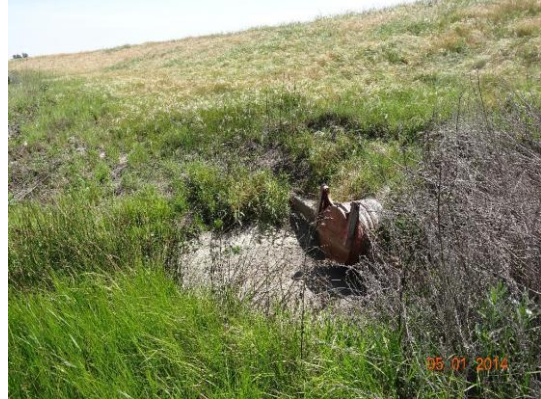
Photo 1 of 3 : UCIP_FA_2015_5033.jpg

LM Start	3.61	Rating **	M	Issue No.	277
LM End	3.61	Issue Type +	En	Location *	LS
Category	Supplemental			GPS Latitude/Longitude	
				Start	End
Item	DWR UCIP Field Study			37.278203 °	37.278203 °
				-120.839884 °	-120.839884 °
DWR ID					
Action/Comments					
Inspector Comments: FS_ID:36515					
DS_ID:19666					
EP_NO: N/A					
FS_HLM: 3.62					
Repair Type: Non-Urgent					
Crossing Status: Found

Flap gate visible on waterward side.

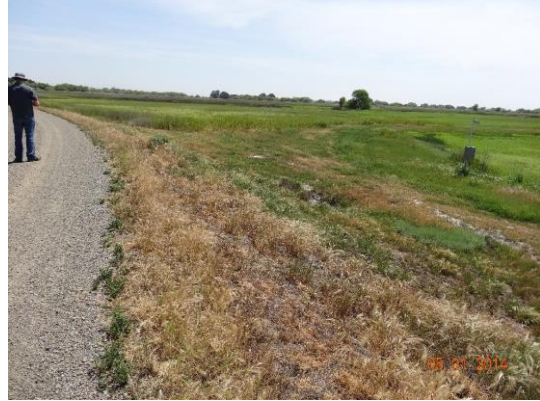
Photo 3 of 3 : UCIP_FA_2015_5035.jpg

LM Start	3.61	Rating **	M	Issue No.	277 (cont)
LM End	3.61	Issue Type +	En	Location *	LS
Category	Supplemental			GPS Latitude/Longitude	
				Start	End
Item	DWR UCIP Field Study			37.278203 °	37.278203 °
				-120.839884 °	-120.839884 °
DWR ID					
Action/Comments					
Inspector Comments: FS_ID:36515 DS_ID:19666 EP_NO: N/A FS_HLM: 3.62 Repair Type: Non-Urgent Crossing Status: Found

View of landward side.

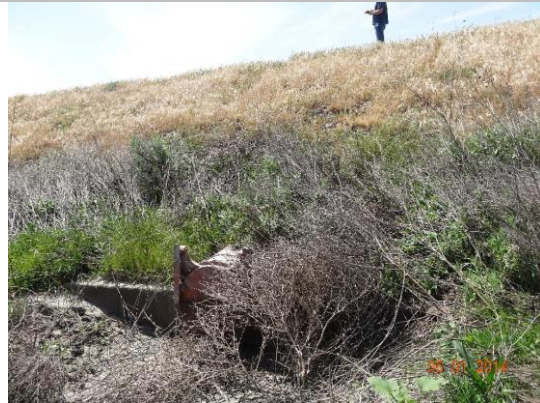
Photo 1 of 3 : UCIP_FA_2015_5036.jpg

LM Start	3.94	Rating **	M	Issue No.	278
LM End	3.94	Issue Type +	En	Location *	LS
Category	Supplemental			GPS Latitude/Longitude	
				Start	End
Item	DWR UCIP Field Study			37.279704 °	37.279704 °
				-120.834709 °	-120.834709 °
DWR ID					
Action/Comments					
Inspector Comments: FS_ID:39364 DS_ID:19667 EP_NO: N/A FS_HLM: 3.96 Repair Type: Non-Urgent Crossing Status: Found UCIP Comments: Signs of erosion or sink hole present on landward toe--Need to contact owner. Dense vegetation limits the inspector's visibility to identify signs of pipe failure (leaks) along the slope. Recommend removing vegetation along pipe alignment to conduct proper inspection of structure. FIELD_STRUCT_DESC: 24-inch CM pipe through the levee, 8.6 feet below the crown. Flap gate on the waterward end. Brass cap No. 130 BM on headwall on the landward side. (USACE-1967). This entry matches the Drainage or Irrigation Structure referenced in O&M manual (HLM 3.95). FS Date: 05/01/2014

Flap gate and concrete headwall visible through dense vegetation.

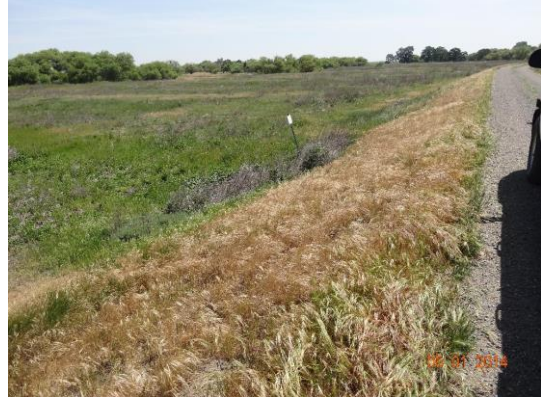
Photo 2 of 3 : UCIP_FA_2015_5037.jpg

Item	DWR UCIP Field Study			37.279704 °	37.279704 °	
				-120.834709 °	-120.834709 °	
DWR ID						
Action/Comments						
Inspector Comments: FS_ID:39364 DS_ID:19667 EP_NO: N/A FS_HLM: 3.96 Repair Type: Non-Urgent Crossing Status: Found UCIP Comments: Signs of erosion or sink hole present on landward toe--Need to contact owner. Dense vegetation limits the inspector's visibility to identify signs of pipe failure (leaks) along the slope. Recommend removing vegetation along pipe alignment to conduct proper inspection of structure. FIELD_STRUCT_DESC: 24-inch CM pipe through the levee, 8.6 feet below the crown. Flap gate on the waterward end. Brass cap No. 130 BM on headwall on the landward side. (USACE-1967). This entry matches the Drainage or Irrigation Structure referenced in O&M manual (HLM 3.95). FS Date: 05/01/2014

View of waterward side.

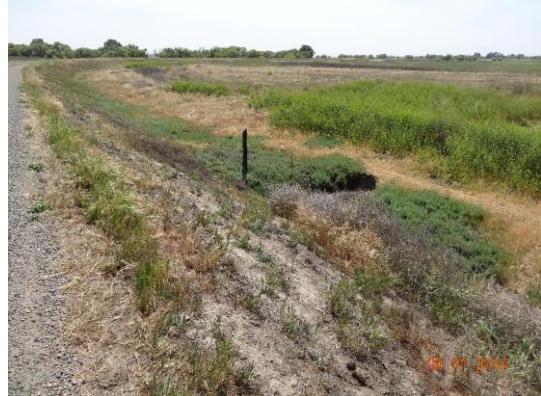
Photo 3 of 3 : UCIP_FA_2015_5038.jpg

View of landward side.

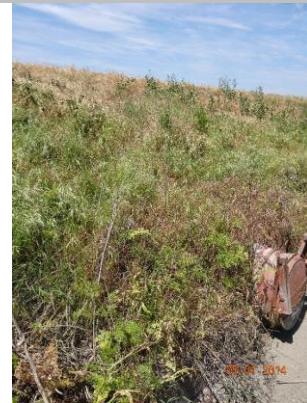
Photo 1 of 3 : UCIP_FA_2015_5039.jpg

LM Start	5.41	Rating **	M	Issue No.	279
LM End	5.41	Issue Type +	En	Location *	CR
Category	Supplemental			GPS Latitude/Longitude	
				Start	End
Item	DWR UCIP Field Study			37.260069 °	37.260069 °
				-120.831768 °	-120.831768 °
DWR ID					
Action/Comments					
Inspector Comments: FS_ID:36517 DS_ID:19668 EP_NO: N/A FS_HLM: 5.43 Repair Type: Non-Urgent Crossing Status: Found UCIP Comments: Dense vegetation limits the inspector's visibility to identify signs of pipe failure (leaks) along the slope. Recommend removing vegetation along pipe alignment to conduct proper inspection of structure. FIELD_STRUCT_DESC: 24-inch CM pipe through the levee, 8.0 feet below the crown. Flap gate on the waterward end. Brass cap No. 125 BM on headwall on the landward side. (USACE-1967). This entry matches the Drainage or Irrigation Structure referenced in O&M manual (HLM 5.43). FS Date: 05/01/2014

View of waterward slope covered by vegetation.

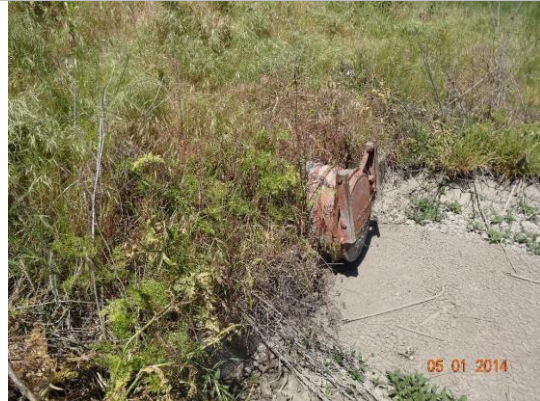
Photo 2 of 3 : UCIP_FA_2015_5040.jpg

LM Start	5.41	Rating **	M	Issue No.	279 (cont)
LM End	5.41	Issue Type +	En	Location *	CR
Category	Supplemental			GPS Latitude/Longitude	
				Start	End
Item	DWR UCIP Field Study			37.260069 °	37.260069 °
				-120.831768 °	-120.831768 °
DWR ID					
Action/Comments					
Inspector Comments: FS_ID:36517 DS_ID:19668 EP_NO: N/A FS_HLM: 5.43 Repair Type: Non-Urgent Crossing Status: Found UCIP Comments: Dense vegetation limits the inspector's visibility to identify signs of pipe failure (leaks) along the slope. Recommend removing vegetation along pipe alignment to conduct proper inspection of structure. FIELD_STRUCT_DESC: 24-inch CM pipe through the levee, 8.0 feet below the crown. Flap gate on the waterward end. Brass cap No. 125 BM on headwall on the landward side. (USACE-1967). This entry matches the Drainage or Irrigation Structure referenced in O&M manual (HLM 5.43). FS Date: 05/01/2014

Flap gate visible on waterward side.

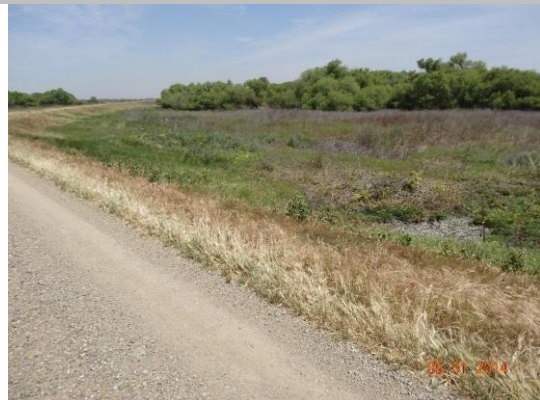
Photo 3 of 3 : UCIP_FA_2015_5041.jpg

View of waterward side.

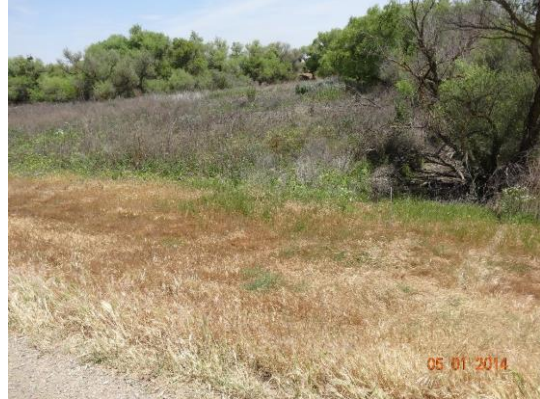
Photo 1 of 2 : UCIP_FA_2015_5042.jpg

LM Start	6.03	Rating **	M	Issue No.	280
LM End	6.03	Issue Type +	En	Location *	CR
Category	Supplemental			GPS Latitude/Longitude	
				Start	End
Item	DWR UCIP Field Study			37.253527 °	37.253527 °
				-120.823991 °	-120.823991 °
DWR ID					
Action/Comments					
Inspector Comments: FS_ID:36518 DS_ID:19669 EP_NO: N/A FS_HLM: 6.06 Repair Type: Non-Urgent Crossing Status: Found

View of waterward side.

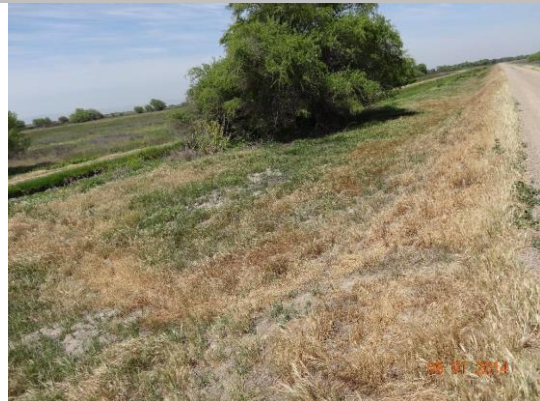
Photo 2 of 2 : UCIP_FA_2015_5043.jpg

View of landward side.

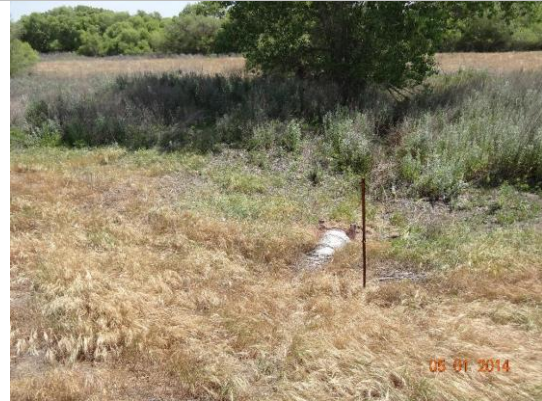
Photo 1 of 3 : UCIP_FA_2015_5092.jpg

LM Start	6.47	Rating **	M	Issue No.	281
LM End	6.47	Issue Type +	En	Location *	CR
Category	Supplemental			GPS Latitude/Longitude	
				Start	End
Item	DWR UCIP Field Study			37.248210 °	37.248210 °
				-120.823120 °	-120.823120 °
DWR ID					
Action/Comments					
Inspector Comments: FS_ID:36519 DS_ID:19670 EP_NO: N/A FS_HLM: 6.49 Repair Type: Non-Urgent Crossing Status: Found

Crossing and flap gate visible on waterward side.

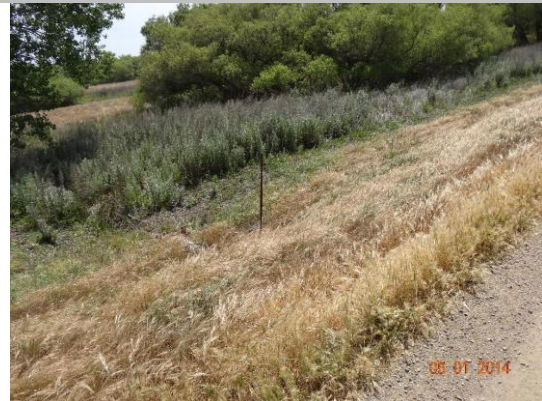
Photo 2 of 3 : UCIP_FA_2015_5093.jpg

View of waterward side.

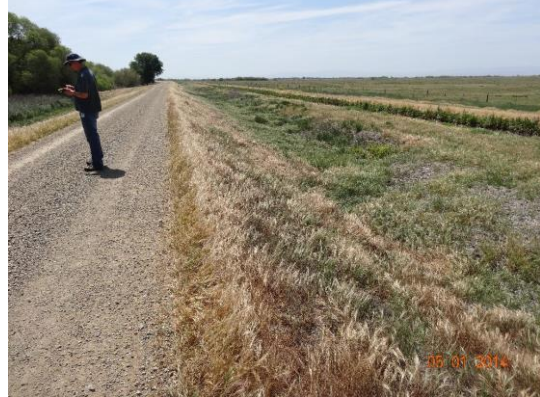
Photo 3 of 3 : UCIP_FA_2015_5094.jpg

LM Start	6.47	Rating **	M	Issue No.	281 (cont)
LM End	6.47	Issue Type +	En	Location *	CR
Category	Supplemental			GPS Latitude/Longitude	
				Start	End
Item	DWR UCIP Field Study			37.248210 °	37.248210 °
				-120.823120 °	-120.823120 °
DWR ID					
Action/Comments					
Inspector Comments: FS_ID:36519					
DS_ID:19670					
EP_NO: N/A					
FS_HLM: 6.49					
Repair Type: Non-Urgent					
Crossing Status: Found

Overview of levee crown and landward slope.

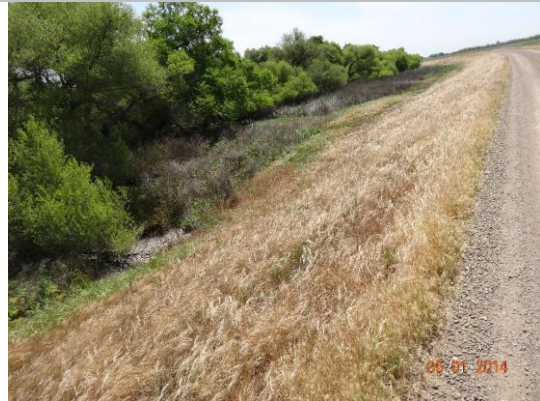
Photo 1 of 3 : UCIP_FA_2015_5095.jpg

LM Start	7.02	Rating **	M	Issue No.	282
LM End	7.02	Issue Type +	En	Location *	CR
Category	Supplemental			GPS Latitude/Longitude	
				Start	End
Item	DWR UCIP Field Study			37.240333 °	37.240333 °
				-120.821490 °	-120.821490 °
DWR ID					
Action/Comments					
Inspector Comments: FS_ID:39365 DS_ID:19671 EP_NO: N/A FS_HLM: 7.05 Repair Type: Non-Urgent Crossing Status: Found UCIP Comments: Dense vegetation limits the inspector's visibility to identify signs of pipe failure (leaks) along the slope. Recommend removing vegetation along pipe alignment to conduct proper inspection of structure. Pipe extension visible on landward side--need to contact owner for additional information about extension/modification. FIELD_STRUCT_DESC: 24-inch CM pipe through the levee, 12.6 feet below the crown. Flap gate on the waterward end. Brass cap No. 125 BM on headwall on the landward side. (USACE-1967). This entry matches the Drainage or Irrigation Structure referenced in O&M manual (HLM 7.05). FS Date: 05/01/2014

View of waterward side.

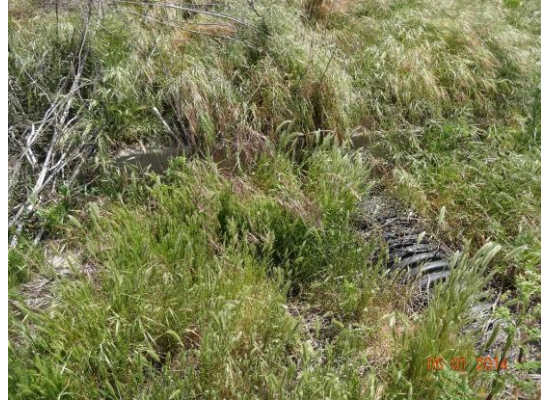
Photo 2 of 3 : UCIP_FA_2015_5096.jpg

LM Start	7.02	Rating **	M	Issue No.	282 (cont)
LM End	7.02	Issue Type +	En	Location *	CR
Category	Supplemental			GPS Latitude/Longitude	
				Start	End
Item	DWR UCIP Field Study			37.240333 °	37.240333 °
				-120.821490 °	-120.821490 °
DWR ID					
Action/Comments					
Inspector Comments: FS_ID:39365 DS_ID:19671 EP_NO: N/A FS_HLM: 7.05 Repair Type: Non-Urgent Crossing Status: Found UCIP Comments: Dense vegetation limits the inspector's visibility to identify signs of pipe failure (leaks) along the slope. Recommend removing vegetation along pipe alignment to conduct proper inspection of structure. Pipe extension visible on landward side--need to contact owner for additional information about extension/modification. FIELD_STRUCT_DESC: 24-inch CM pipe through the levee, 12.6 feet below the crown. Flap gate on the waterward end. Brass cap No. 125 BM on headwall on the landward side. (USACE-1967). This entry matches the Drainage or Irrigation Structure referenced in O&M manual (HLM 7.05). FS Date: 05/01/2014

Pipe extension visible on landward side attached to inlet at concrete headwall.

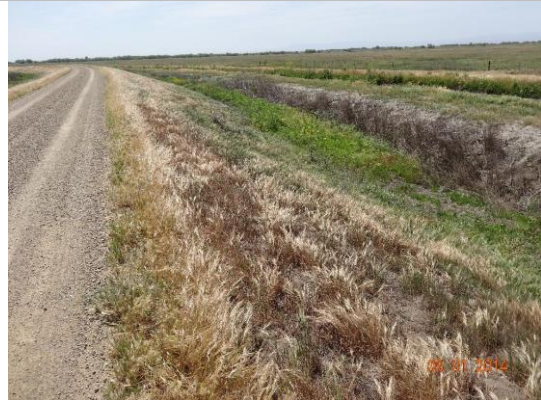
Photo 3 of 3 : UCIP_FA_2015_5097.jpg

LM Start	7.02	Rating **	M	Issue No.	282 (cont)
LM End	7.02	Issue Type +	En	Location *	CR

View of landward side.

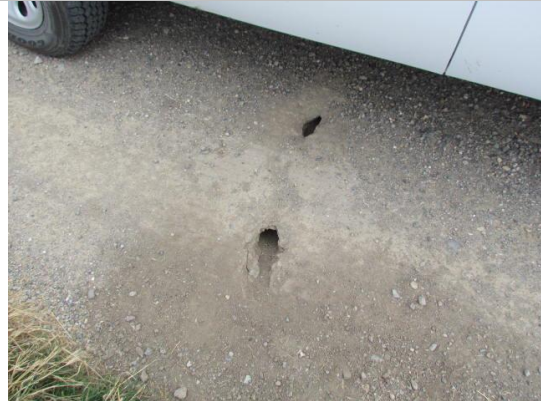
Photo 1 of 1 : FA_2015_NA0010_119_252_20150914_00006.jpg

LM Start	7.71	Rating **	A/W	Issue No.	252
LM End	7.71	Issue Type +	Ma	Location *	CR
Category	Earthen Levee			GPS Latitude/Longitude	
				Start	End
Item	Animal Control			37.232828 °	37.232828 °
				-120.813799 °	-120.813799 °
DWR ID	DWR_NA0010_02A_s _ 2015_252				
Action/Comments					
No rodents visible, but rodent burrows visible; need to backfill and compact or grout burrows.					
Inspector Comments: Two rodent holes on levee crown.

Looking at rodent holes on levee crown.

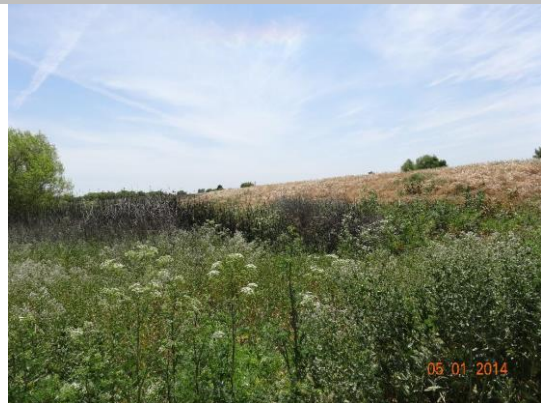
Photo 1 of 3 : UCIP_FA_2015_5098.jpg

LM Start	7.74	Rating **	M	Issue No.	283
LM End	7.74	Issue Type +	En	Location *	CR
Category	Supplemental			GPS Latitude/Longitude	
				Start	End
Item	DWR UCIP Field Study			37.232650 °	37.232650 °
				-120.813363 °	-120.813363 °
DWR ID					
Action/Comments					
Inspector Comments: FS_ID:36521 DS_ID:19673 EP_NO: N/A FS_HLM: 7.77 Repair Type: Non-Urgent Crossing Status: Found UCIP Comments: Dense vegetation limits the inspector's visibility to identify signs of pipe failure (leaks) along the slope. Recommend removing vegetation along pipe alignment to conduct proper inspection of structure. FIELD_STRUCT_DESC: 24-inch CM pipe through the levee, 8.0 feet below the crown. Flap gate on the waterward end. Brass cap No. 125 BM on headwall on the landward side. (USACE-1967). This entry matches the Drainage or Irrigation Structure referenced in O&M manual (HLM 7.77). FS Date: 05/01/2014

View of waterward side--photo taken from levee toe looking towards alignment of crossing.

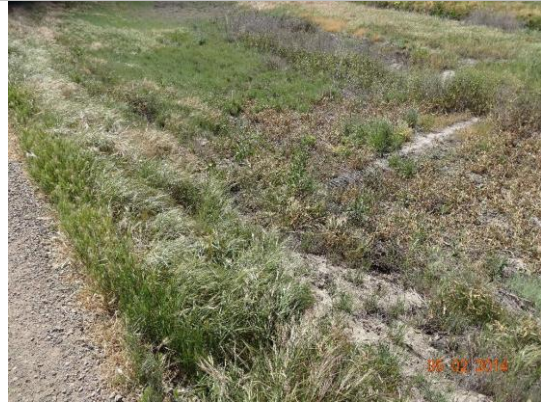
Photo 2 of 3 : UCIP_FA_2015_5099.jpg

LM Start	7.74	Rating **	M	Issue No.	283 (cont)
LM End	7.74	Issue Type +	En	Location *	CR
Category	Supplemental			GPS Latitude/Longitude	
				Start	End
Item	DWR UCIP Field Study			37.232650 °	37.232650 °
				-120.813363 °	-120.813363 °
DWR ID					
Action/Comments					
Inspector Comments: FS_ID:36521 DS_ID:19673 EP_NO: N/A FS_HLM: 7.77 Repair Type: Non-Urgent Crossing Status: Found UCIP Comments: Dense vegetation limits the inspector's visibility to identify signs of pipe failure (leaks) along the slope. Recommend removing vegetation along pipe alignment to conduct proper inspection of structure. FIELD_STRUCT_DESC: 24-inch CM pipe through the levee, 8.0 feet below the crown. Flap gate on the waterward end. Brass cap No. 125 BM on headwall on the landward side. (USACE-1967). This entry matches the Drainage or Irrigation Structure referenced in O&M manual (HLM 7.77). FS Date: 05/01/2014

View of landward side.

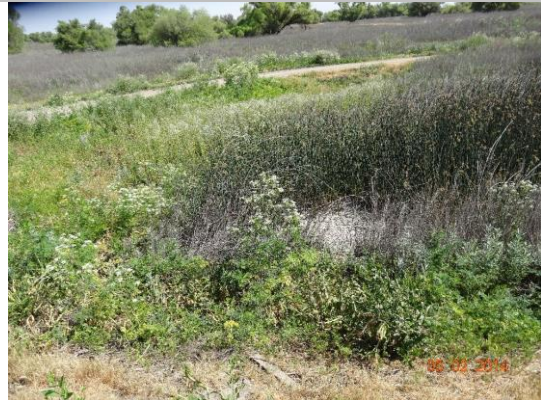
Photo 3 of 3 : UCIP_FA_2015_5100.jpg

View of waterward side.

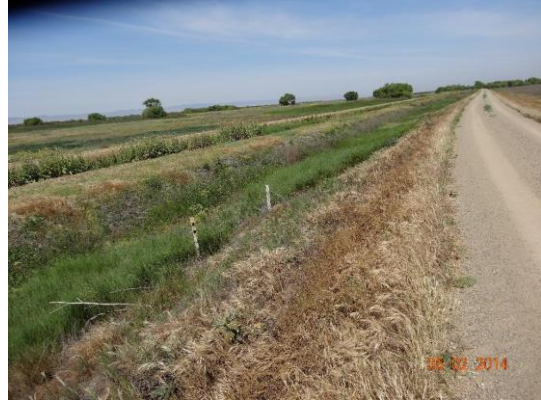
Photo 1 of 3 : UCIP_FA_2015_5101.jpg

Inspector Comments: FS_ID:39366
 DS_ID:19674
 EP_NO: N/A
 FS_HLM: 8.16
 Repair Type: Non-Urgent
 Crossing Status: Found
 UCIP Comments: Dense vegetation limits the inspector's visibility to identify signs of pipe failure (leaks) along the slope and landward headwall. Recommend removing vegetation along pipe alignment and toe to conduct proper inspection of structure. Sediment buildup in pipe visible from landward side--recommend clearing.
 FIELD_STRUCT_DESC: 24-inch CM pipe through the levee, 9.0 feet below the crown. Flap gate on the waterward end. Brass cap No. 120 BM on headwall on the landward side. (USACE-1967). This entry matches the Drainage or Irrigation Structure referenced in O&M manual (HLM 8.16).
 FS Date: 05/14/2014

View of landward side.

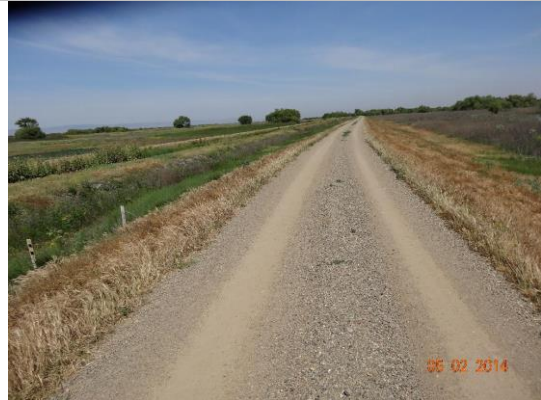
Photo 2 of 3 : UCIP_FA_2015_5102.jpg

Overview of levee crown at crossing.

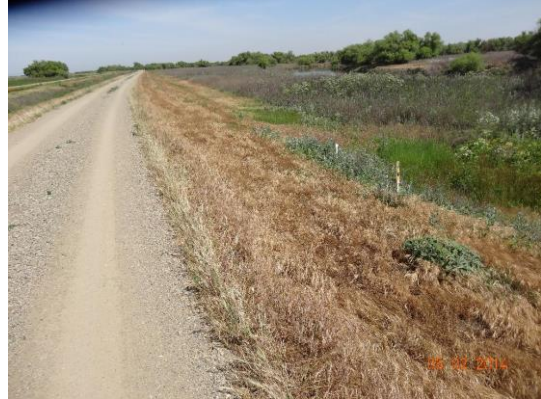
Photo 3 of 3 : UCIP_FA_2015_5103.jpg

LM Start	8.13	Rating **	M	Issue No.	261 (cont)	
LM End	8.13	Issue Type +	En	Location *	LS	
Category	Supplemental			GPS Latitude/Longitude		
				Start	End	
Item	DWR UCIP Field Study			37.228343 °	37.228343 °	
				-120.808789 °	-120.808789 °	
DWR ID						
Action/Comments						
Inspector Comments: FS_ID:39366						
DS_ID:19674						
EP_NO: N/A						
FS_HLM: 8.16						
Repair Type: Non-Urgent						
Crossing Status: Found

View of waterward side.

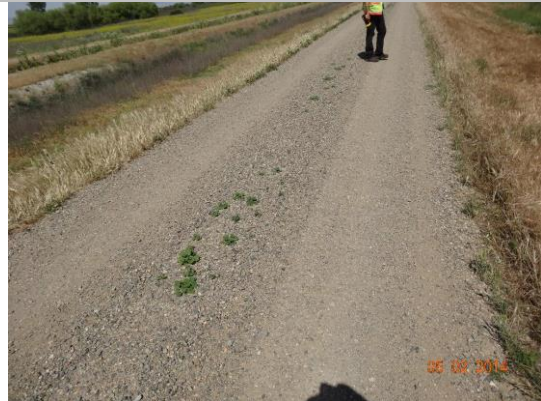
Photo 1 of 3 : UCIP_FA_2015_5205.jpg

LM Start	8.46	Rating **	M	Issue No.	262
LM End	8.46	Issue Type +	En	Location *	LS
Category	Supplemental			GPS Latitude/Longitude	
				Start	End
Item	DWR UCIP Field Study			37.225241 °	37.225241 °
				-120.804286 °	-120.804286 °
DWR ID					
Action/Comments					
Inspector Comments: FS_ID:39367 DS_ID:19675 EP_NO: N/A FS_HLM: 8.49 Repair Type: Non-Urgent Crossing Status: Found UCIP Comments: Dense vegetation on landward toe. Also dense vegetation limits the inspector's visibility to identify signs of pipe failure (leaks) along waterward slope. Recommend removing vegetation along pipe alignment toe to conduct proper inspection of structure. Sediment buildup in pipe--recommend clearing. FIELD_STRUCT_DESC: 24-inch CM pipe through the levee, 9.4 feet below the crown. Flap gate on the waterward end. Brass cap No. 120 BM on headwall on the landward side. (USACE-1967). This entry matches the Drainage or Irrigation Structure referenced in O&M manual (HLM 8.48). FS Date: 05/14/2014

Overview of levee crown at crossing.

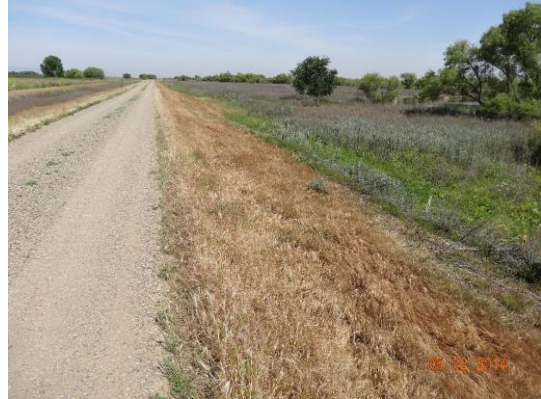
Photo 2 of 3 : UCIP_FA_2015_5206.jpg

Inspector Comments: FS_ID:39367
 DS_ID:19675
 EP_NO: N/A
 FS_HLM: 8.49
 Repair Type: Non-Urgent
 Crossing Status: Found
 UCIP Comments: Dense vegetation on landward toe. Also dense vegetation limits the inspector's visibility to identify signs of pipe failure (leaks) along waterward slope. Recommend removing vegetation along pipe alignment toe to conduct proper inspection of structure. Sediment buildup in pipe--recommend clearing.
 FIELD_STRUCT_DESC: 24-inch CM pipe through the levee, 9.4 feet below the crown. Flap gate on the waterward end. Brass cap No. 120 BM on headwall on the landward side. (USACE-1967). This entry matches the Drainage or Irrigation Structure referenced in O&M manual (HLM 8.48).
 FS Date: 05/14/2014

View of waterward side.

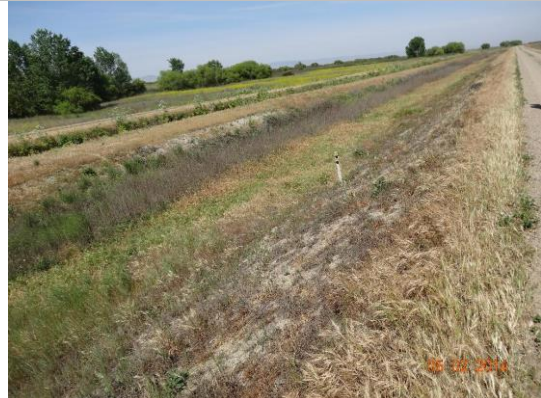
Photo 3 of 3 : UCIP_FA_2015_5207.jpg

View of landward side.

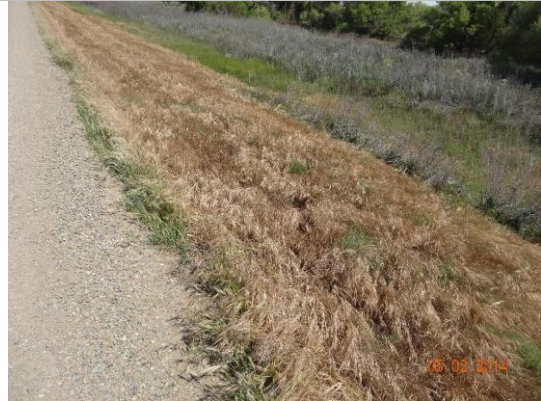
Photo 1 of 3 : UCIP_FA_2015_5208.jpg

LM Start	8.83	Rating **	M	Issue No.	255
LM End	8.83	Issue Type +	En	Location *	LS
Category	Supplemental			GPS Latitude/Longitude	
				Start	End
Item	DWR UCIP Field Study			37.222271 °	37.222271 °
				-120.798705 °	-120.798705 °
DWR ID					
Action/Comments					
Inspector Comments: FS_ID:42503					
DS_ID:19676					
EP_NO: N/A					
FS_HLM: 8.86					
Repair Type: Non-Urgent					
Crossing Status: Found

View of waterward side.

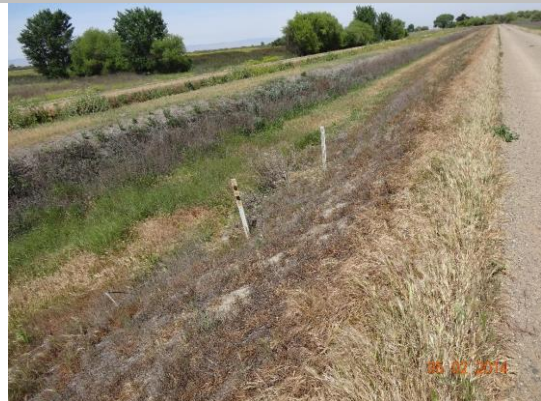
Photo 2 of 3 : UCIP_FA_2015_5209.jpg

LM Start	8.83	Rating **	M	Issue No.	255 (cont)
LM End	8.83	Issue Type +	En	Location *	LS

View of landward side.

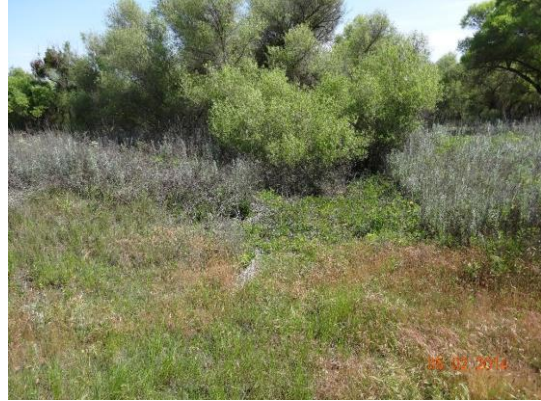
Photo 3 of 3 : UCIP_FA_2015_5210.jpg

LM Start	8.83	Rating **	M	Issue No.	255 (cont)
LM End	8.83	Issue Type +	En	Location *	LS
Category	Supplemental			GPS Latitude/Longitude	
				Start	End
Item	DWR UCIP Field Study			37.222271 °	37.222271 °
				-120.798705 °	-120.798705 °
DWR ID					
Action/Comments					
Inspector Comments: FS_ID:42503					
DS_ID:19676					
EP_NO: N/A					
FS_HLM: 8.86					
Repair Type: Non-Urgent					
Crossing Status: Found

View of waterward toe.

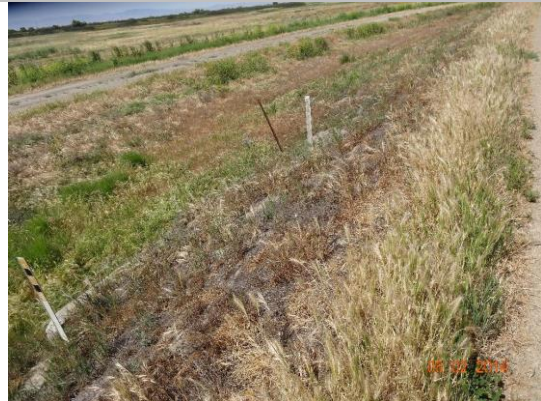
Photo 1 of 3 : UCIP_FA_2015_5211.jpg

LM Start	9.00	Rating **	M	Issue No.	256
LM End	9.00	Issue Type +	En	Location *	LS
Category	Supplemental			GPS Latitude/Longitude	
				Start	End
Item	DWR UCIP Field Study			37.220888 °	37.220888 °
				-120.796394 °	-120.796394 °
DWR ID					
Action/Comments					
Inspector Comments: FS_ID:36525 DS_ID:19677 EP_NO: N/A FS_HLM: 9.03 Repair Type: Non-Urgent Crossing Status: Found UCIP Comments: Dense vegetation limits the inspector's visibility to identify signs of pipe failure (leaks) along the slope. Recommend removing vegetation along pipe alignment to conduct proper inspection of structure. FIELD_STRUCT_DESC: 36-inch CM pipe through the levee, 8.8 feet below the crown. Flap gate on the waterward end. Brass cap No. 120 BM on headwall on the landward side. (USACE-1967). This entry matches the Drainage or Irrigation Structure referenced in O&M manual (HLM 9.02). FS Date: 05/14/2014

View of landward side.

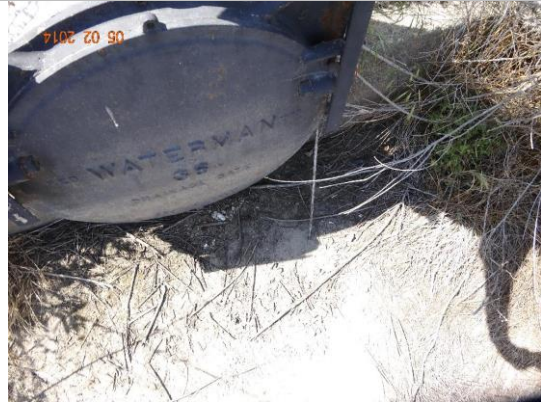
Photo 2 of 3 : UCIP_FA_2015_5212.jpg

Inspector Comments: FS_ID:36525
 DS_ID:19677
 EP_NO: N/A
 FS_HLM: 9.03
 Repair Type: Non-Urgent
 Crossing Status: Found
 UCIP Comments: Dense vegetation limits the inspector's visibility to identify signs of pipe failure (leaks) along the slope. Recommend removing vegetation along pipe alignment to conduct proper inspection of structure.
 FIELD_STRUCT_DESC: 36-inch CM pipe through the levee, 8.8 feet below the crown. Flap gate on the waterward end. Brass cap No. 120 BM on headwall on the landward side. (USACE-1967). This entry matches the Drainage or Irrigation Structure referenced in O&M manual (HLM 9.02).
 FS Date: 05/14/2014

View of flap gate visible from waterward side.
