**Flood Control Project Maintenance
Levee Inspections**

Fall 2015 Levee Maintenance Deficiency Summary Report

San Joaquin River Basin

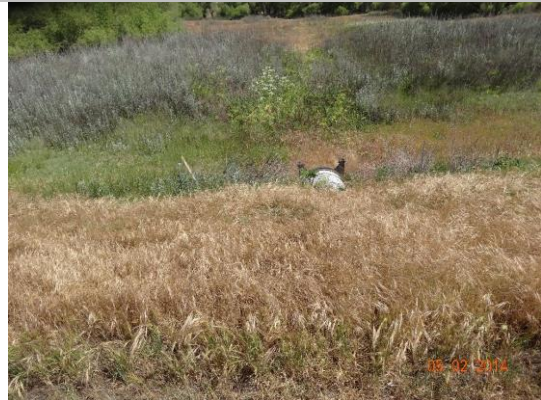
Photo 3 of 3 : UCIP_FA_2015_5213.jpg

Inspector Comments: FS_ID:36525
 DS_ID:19677
 EP_NO: N/A
 FS_HLM: 9.03
 Repair Type: Non-Urgent
 Crossing Status: Found
 UCIP Comments: Dense vegetation limits the inspector's visibility to identify signs of pipe failure (leaks) along the slope. Recommend removing vegetation along pipe alignment to conduct proper inspection of structure.
 FIELD_STRUCT_DESC: 36-inch CM pipe through the levee, 8.8 feet below the crown. Flap gate on the waterward end. Brass cap No. 120 BM on headwall on the landward side. (USACE-1967). This entry matches the Drainage or Irrigation Structure referenced in O&M manual (HLM 9.02).
 FS Date: 05/14/2014

View of waterward side--pipe and flap gate visible.

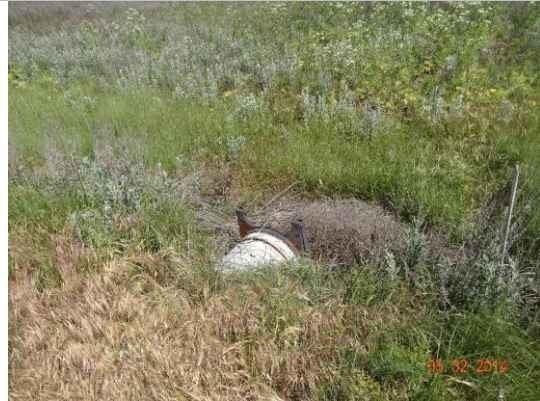
Photo 1 of 3 : UCIP_FA_2015_5214.jpg

LM Start	9.17	Rating **	M	Issue No.	264
LM End	9.17	Issue Type +	En	Location *	LS
Category	Supplemental			GPS Latitude/Longitude	
				Start	End
Item	DWR UCIP Field Study			37.220520 °	37.220520 °
				-120.793277 °	-120.793277 °
DWR ID					
Action/Comments					
Inspector Comments: FS_ID:40443					
DS_ID:19678					
EP_NO: N/A					
FS_HLM: 9.2					
Repair Type: Non-Urgent					
Crossing Status: Found

Pipe visible on waterward side.

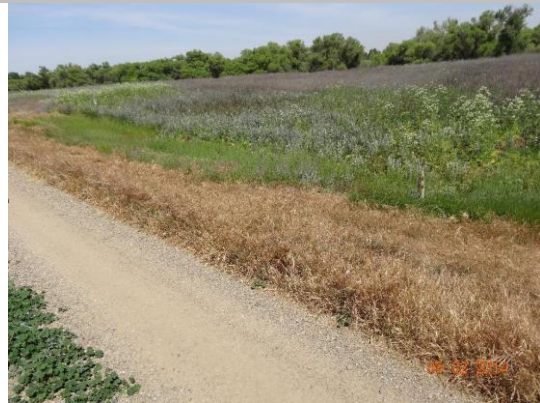
Photo 2 of 3 : UCIP_FA_2015_5215.jpg

View of waterward side.

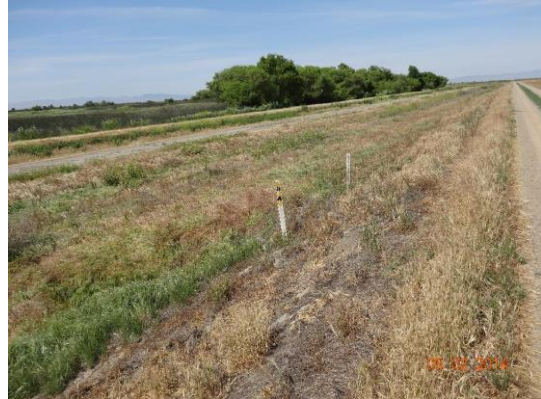
Photo 3 of 3 : UCIP_FA_2015_5216.jpg

LM Start	9.17	Rating **	M	Issue No.	264 (cont)
LM End	9.17	Issue Type +	En	Location *	LS
Category	Supplemental			GPS Latitude/Longitude	
				Start	End
Item	DWR UCIP Field Study			37.220520 °	37.220520 °
				-120.793277 °	-120.793277 °
DWR ID					
Action/Comments					
Inspector Comments: FS_ID:40443 DS_ID:19678 EP_NO: N/A FS_HLM: 9.2 Repair Type: Non-Urgent Crossing Status: Found

View of landward side.

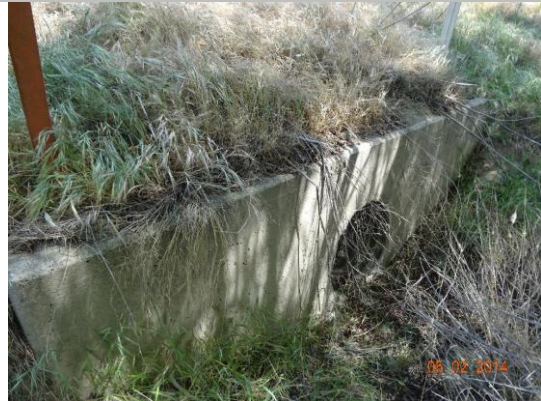
Photo 1 of 3 : UCIP_FA_2015_5257.jpg

LM Start	9.43	Rating **	M	Issue No.	257
LM End	9.43	Issue Type +	En	Location *	LS
Category	Supplemental			GPS Latitude/Longitude	
				Start	End
Item	DWR UCIP Field Study			37.220227 °	37.220227 °
				-120.788634 °	-120.788634 °
DWR ID					
Action/Comments					
Inspector Comments: FS_ID:36527 DS_ID:19686 EP_NO: N/A FS_HLM: 9.46 Repair Type: Non-Urgent Crossing Status: Found UCIP Comments: Dense vegetation limits the inspector's visibility to identify signs of pipe failure (leaks) along the slope. Recommend removing vegetation along pipe alignment to conduct proper inspection of structure. FIELD_STRUCT_DESC: 24-inch CM pipe through the levee, 9.0 feet below the crown. Flap gate on the waterward end. Brass cap No. 115 BM on headwall on the landward side. (USACE-1967). This entry matches the Drainage or Irrigation Structure referenced in O&M manual (HLM 9.46). FS Date: 05/14/2014

Concrete headwall visible on landward side.

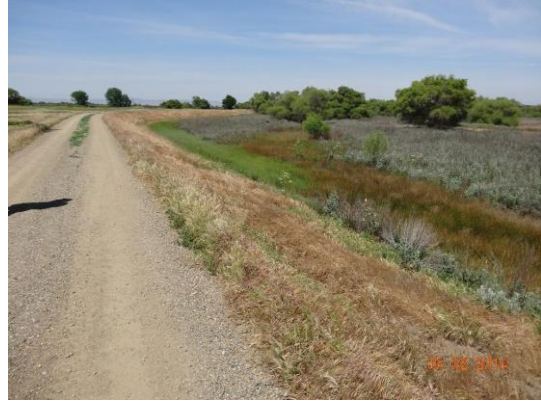
Photo 2 of 3 : UCIP_FA_2015_5258.jpg

LM Start	9.43	Rating **	M	Issue No.	257 (cont)
LM End	9.43	Issue Type +	En	Location *	LS
Category	Supplemental			GPS Latitude/Longitude	
				Start	End
Item	DWR UCIP Field Study			37.220227 °	37.220227 °
				-120.788634 °	-120.788634 °
DWR ID					
Action/Comments					
Inspector Comments: FS_ID:36527 DS_ID:19686 EP_NO: N/A FS_HLM: 9.46 Repair Type: Non-Urgent Crossing Status: Found UCIP Comments: Dense vegetation limits the inspector's visibility to identify signs of pipe failure (leaks) along the slope. Recommend removing vegetation along pipe alignment to conduct proper inspection of structure. FIELD_STRUCT_DESC: 24-inch CM pipe through the levee, 9.0 feet below the crown. Flap gate on the waterward end. Brass cap No. 115 BM on headwall on the landward side. (USACE-1967). This entry matches the Drainage or Irrigation Structure referenced in O&M manual (HLM 9.46). FS Date: 05/14/2014

View of waterward side.

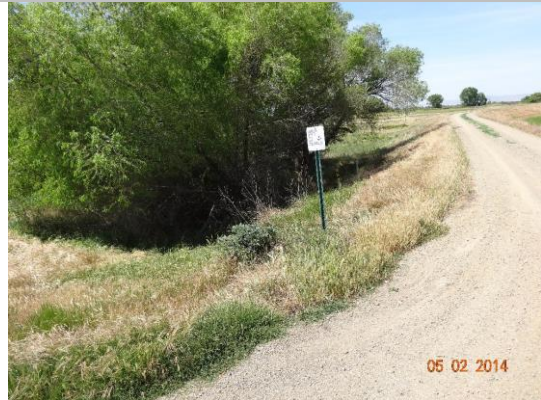
Photo 3 of 3 : UCIP_FA_2015_5259.jpg

View of landward side.

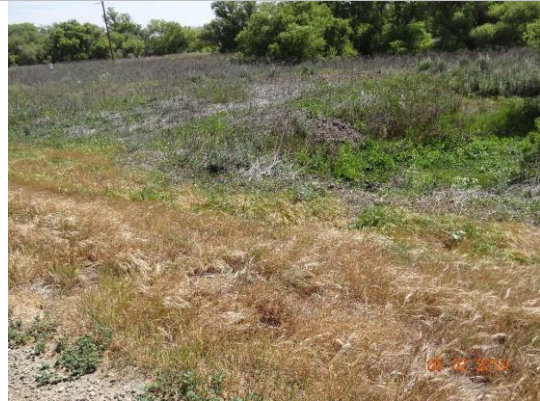
Photo 1 of 3 : UCIP_FA_2015_5260.jpg

LM Start	10.09	Rating **	M	Issue No.	258
LM End	10.09	Issue Type +	En	Location *	LS
Category	Supplemental			GPS Latitude/Longitude	
				Start	End
Item	DWR UCIP Field Study			37.214229 °	37.214229 °
				-120.784350 °	-120.784350 °
DWR ID					
Action/Comments					
Inspector Comments: FS_ID:36528 DS_ID:19687 EP_NO: N/A FS_HLM: 10.126 Repair Type: Non-Urgent Crossing Status: Found UCIP Comments: Dense vegetation limits the inspector's visibility to identify signs of pipe failure (leaks) along the slope. Recommend removing vegetation along pipe alignment to conduct proper inspection of structure. FIELD_STRUCT_DESC: 24-inch CM pipe through the levee, 11.7 feet below the crown. Flap gate on the waterward end. Brass cap No. 115 BM on headwall on the landward side. (USACE-1967). This entry matches the Drainage or Irrigation Structure referenced in O&M manual (HLM 10.12). FS Date: 05/14/2014

View of waterward side.

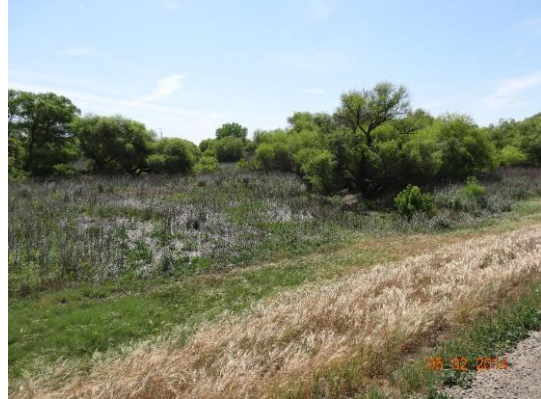
Photo 2 of 3 : UCIP_FA_2015_5261.jpg

LM Start	10.09	Rating **	M	Issue No.	258 (cont)
LM End	10.09	Issue Type +	En	Location *	LS
Category	Supplemental			GPS Latitude/Longitude	
				Start	End
Item	DWR UCIP Field Study			37.214229 °	37.214229 °
				-120.784350 °	-120.784350 °
DWR ID					
Action/Comments					
Inspector Comments: FS_ID:36528 DS_ID:19687 EP_NO: N/A FS_HLM: 10.126 Repair Type: Non-Urgent Crossing Status: Found UCIP Comments: Dense vegetation limits the inspector's visibility to identify signs of pipe failure (leaks) along the slope. Recommend removing vegetation along pipe alignment to conduct proper inspection of structure. FIELD_STRUCT_DESC: 24-inch CM pipe through the levee, 11.7 feet below the crown. Flap gate on the waterward end. Brass cap No. 115 BM on headwall on the landward side. (USACE-1967). This entry matches the Drainage or Irrigation Structure referenced in O&M manual (HLM 10.12). FS Date: 05/14/2014

Overview of waterward side.

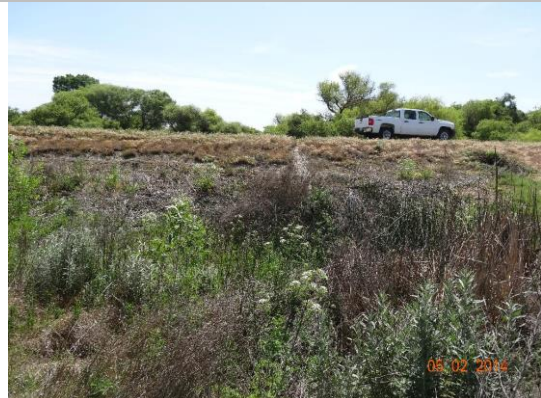
Photo 3 of 3 : UCIP_FA_2015_5262.jpg

View of waterward slope.

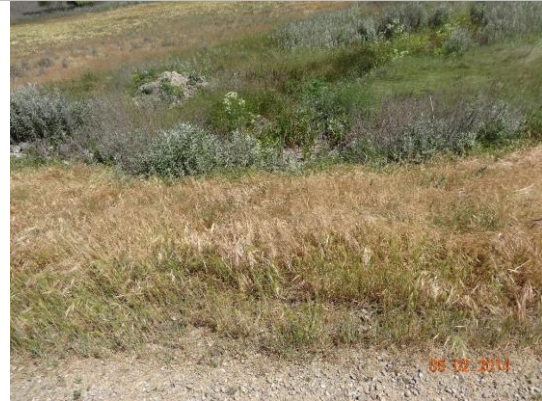
Photo 1 of 3 : UCIP_FA_2015_4764.jpg

LM Start	10.78	Rating **	M	Issue No.	254
LM End	10.78	Issue Type +	En	Location *	LS
Category	Supplemental			GPS Latitude/Longitude	
				Start	End
Item	DWR UCIP Field Study			37.206352 °	37.206352 °
				-120.777634 °	-120.777634 °
DWR ID					
Action/Comments					
Inspector Comments: FS_ID:42504					
DS_ID:19688					
EP_NO: N/A					
FS_HLM: 10.81					
Repair Type: Non-Urgent					
Crossing Status: Found

View of waterward side.

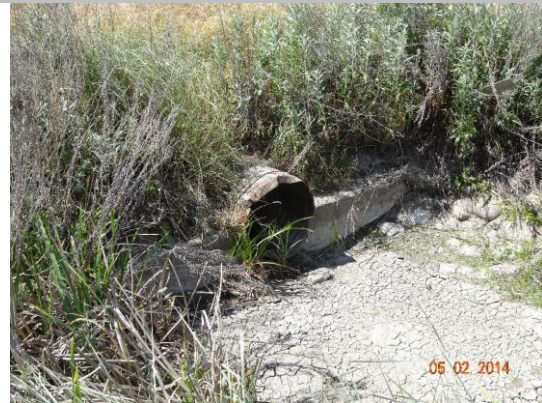
Photo 2 of 3 : UCIP_FA_2015_4765.jpg

View of pipe visible on waterward side.

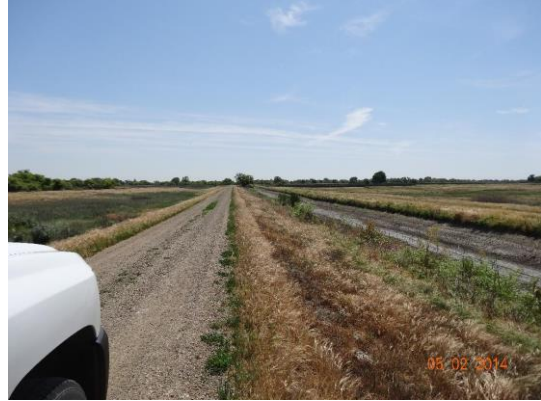
Photo 3 of 3 : UCIP_FA_2015_5263.jpg

LM Start	10.78	Rating **	M	Issue No.	254 (cont)
LM End	10.78	Issue Type +	En	Location *	LS
Category	Supplemental			GPS Latitude/Longitude	
				Start	End
Item	DWR UCIP Field Study			37.206352 °	37.206352 °
				-120.777634 °	-120.777634 °
DWR ID					
Action/Comments					
Inspector Comments: FS_ID:42504					
DS_ID:19688					
EP_NO: N/A					
FS_HLM: 10.81					
Repair Type: Non-Urgent					
Crossing Status: Found

View of landward side.

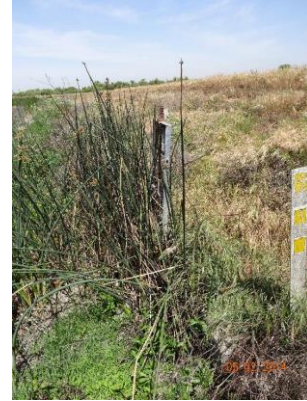
Photo 1 of 2 : UCIP_FA_2015_4766.jpg

LM Start	11.14	Rating **	M	Issue No.	259
LM End	11.14	Issue Type +	En	Location *	LS
Category	Supplemental			GPS Latitude/Longitude	
				Start	End
Item	DWR UCIP Field Study			37.204640 °	37.204640 °
				-120.771564 °	-120.771564 °
DWR ID					
Action/Comments					
Inspector Comments: FS_ID:36530 DS_ID:19689 EP_NO: N/A FS_HLM: 11.17 Repair Type: Non-Urgent Crossing Status: Found UCIP Comments: Dense vegetation limits the inspector's visibility to identify signs of pipe failure (leaks) along the slope. Recommend removing vegetation along pipe alignment to conduct proper inspection of structure. FIELD_STRUCT_DESC: 24-inch CM pipe through the levee, 8.0 feet below the crown. Flap gate on the waterward end. Screw gate on the landward end. Brass cap No. 115 BM on headwall on the landward side. (USACE-1967). This entry matches the Drainage or Irrigation Structure referenced in O&M manual (HLM 11.17). FS Date: 05/14/2014

Slide gate visible on landward side blocked by vegetation.

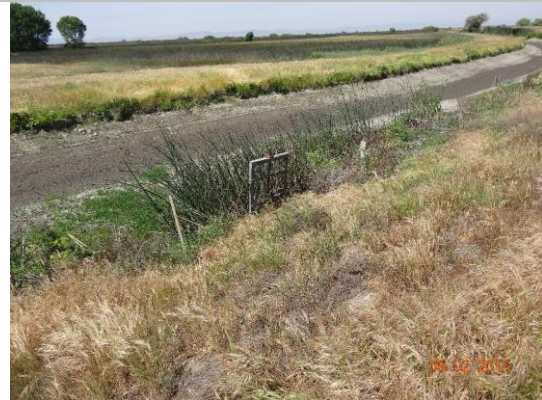
Photo 2 of 2 : UCIP_FA_2015_4767.jpg

View of landward slope.

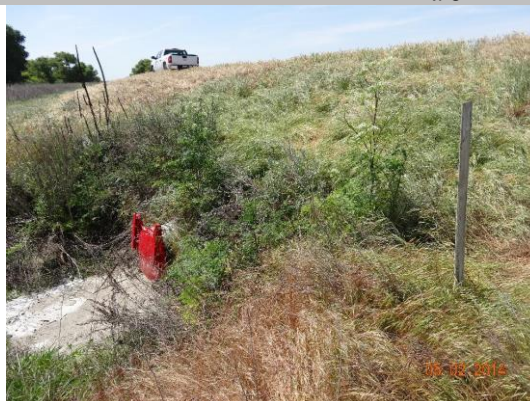
Photo 1 of 3 : UCIP_FA_2015_4768.jpg

LM Start	11.40	Rating **	M	Issue No.	260
LM End	11.40	Issue Type +	En	Location *	LS
Category	Supplemental			GPS Latitude/Longitude	
				Start	End
Item	DWR UCIP Field Study			37.201792 °	37.201792 °
				-120.768462 °	-120.768462 °
DWR ID					
Action/Comments					
Inspector Comments: FS_ID:36531					
DS_ID:19690					
EP_NO: N/A					
FS_HLM: 11.43					
Repair Type: Non-Urgent					
Crossing Status: Found

Flap gate visible on waterward toe.

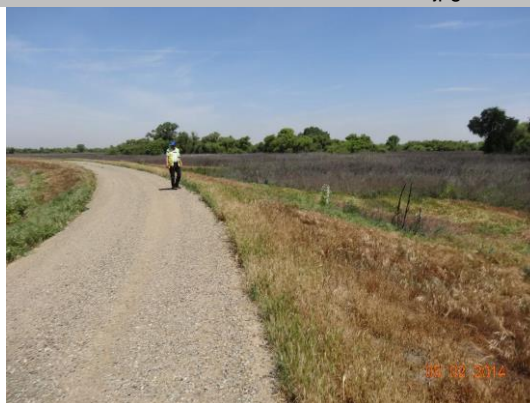
Photo 2 of 3 : UCIP_FA_2015_4769.jpg

View of waterward side.

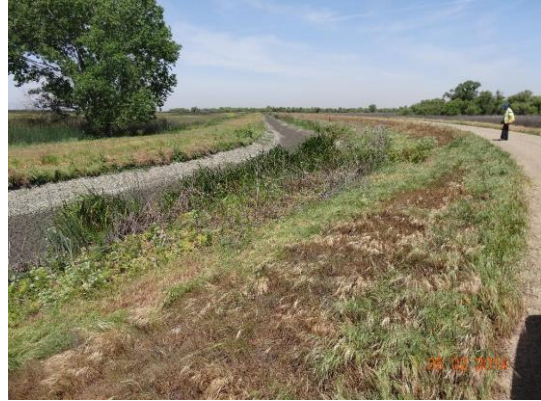
Photo 3 of 3 : UCIP_FA_2015_4770.jpg

LM Start	11.40	Rating **	M	Issue No.	260 (cont)	
LM End	11.40	Issue Type +	En	Location *	LS	
Category	Supplemental			GPS Latitude/Longitude		
				Start	End	
Item	DWR UCIP Field Study			37.201792 °	37.201792 °	
				-120.768462 °	-120.768462 °	
DWR ID						
Action/Comments						
Inspector Comments: FS_ID:36531						
DS_ID:19690						
EP_NO: N/A						
FS_HLM: 11.43						
Repair Type: Non-Urgent						
Crossing Status: Found

View of landward side.

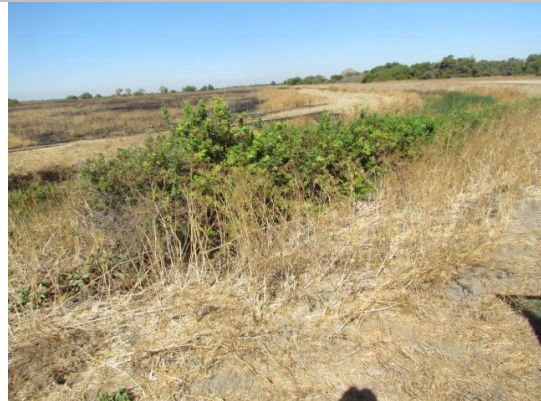
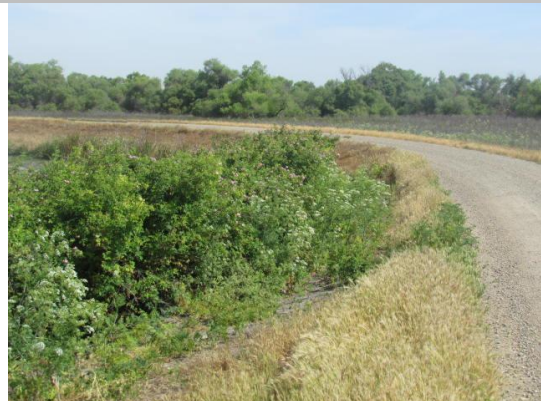
LM Start	12.10	Rating **	M	Issue No.	5
LM End	12.10	Issue Type +	Ma	Location *	LS
Category	Earthen Levee			GPS Latitude/Longitude	
				Start	End
Item	Vegetation			37.193504 °	37.193504 °
				-120.763859 °	-120.763859 °
DWR ID	DWR_NA0010_02B_s_2012_5				
Action/Comments					
Remove the wild growth other than native grasses from the levee slopes.					
Inspector Comments: Remove wild roses from landside toe.

Looking downstream at wildroses on landward slope. Fall 2015

Looking north at wildroses on landward slope. Spring 2015

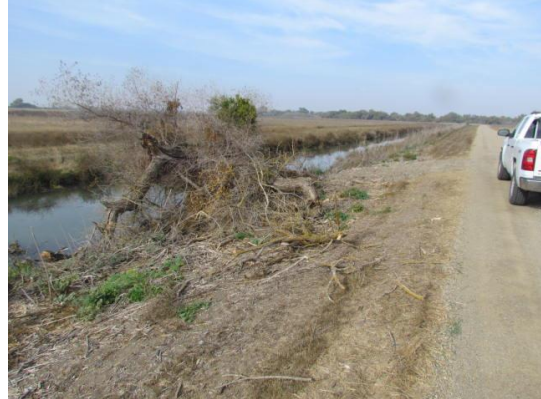
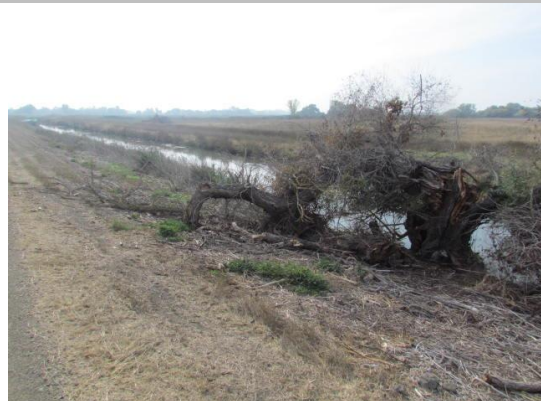
LM Start	12.21	Rating **	M	Issue No.	1
LM End	12.25	Issue Type +	Ma	Location *	LS
Category	Earthen Levee			GPS Latitude/Longitude	
				Start	End
Item	Encroachments			37.191495 °	37.191500 °
				-120.764551 °	-120.764521 °
DWR ID	DWR_NA0010_02B_f_2014_1				
Action/Comments					
Tree or limb					
Inspector Comments: Fallen tree limbs on landward slope.

Looking southwest at tree limb on waterward slope.

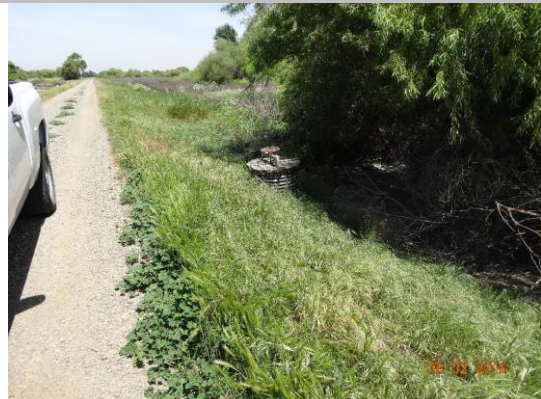
Photo 1 of 3 : UCIP_FA_2015_4771.jpg

LM Start	13.18	Rating **	M	Issue No.	263
LM End	13.18	Issue Type +	En	Location *	LS
Category	Supplemental			GPS Latitude/Longitude	
				Start	End
Item	DWR UCIP Field Study			37.179265 °	37.179265 °
				-120.764870 °	-120.764870 °
DWR ID					
Action/Comments					
Inspector Comments: FS_ID:39370 DS_ID:19663 EP_NO: N/A FS_HLM: 13.22 Repair Type: Non-Urgent Crossing Status: Found

View of waterward side.

Inspector Comments: FS_ID:39370
 DS_ID:19663
 EP_NO: N/A
 FS_HLM: 13.22
 Repair Type: Non-Urgent
 Crossing Status: Found
 UCIP Comments: Dense vegetation limits the inspector's visibility to identify signs of pipe failure (leaks) along the slope. Recommend removing vegetation along pipe alignment to conduct proper inspection of structure. Sediment buildup in pipe--recommend clearing.
 FIELD_STRUCT_DESC: 24-inch CM pipe through the levee, 6.5 feet below the crown. Slide gate in pipe riser on the waterward slope. (USACE-1967). This entry matches the Drainage or Irrigation Structure referenced in O&M manual (HLM 13.22).
 FS Date: 05/14/2014

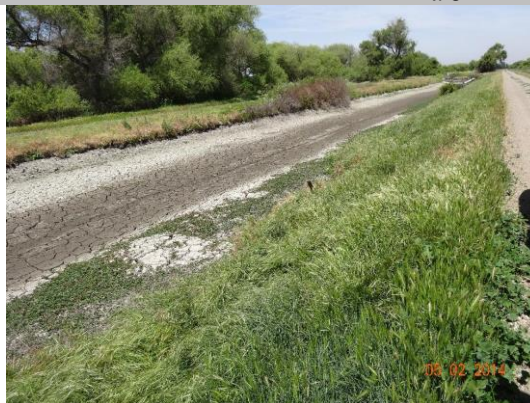
Photo 2 of 3 : UCIP_FA_2015_4772.jpg

Overview of landward slope.

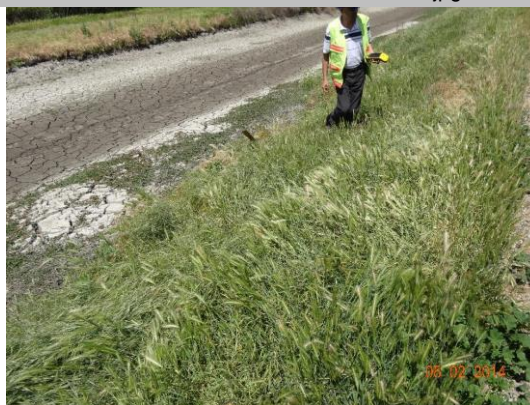
Photo 3 of 3 : UCIP_FA_2015_4773.jpg

View of landward side.

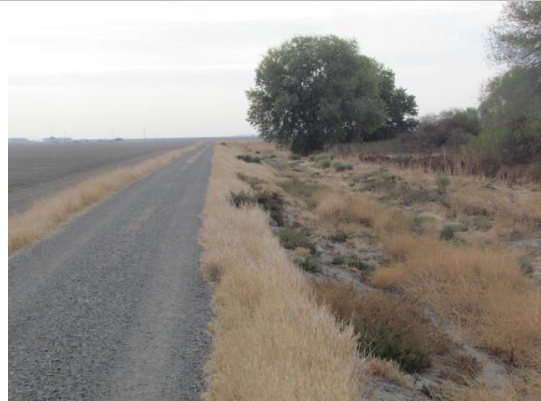
Photo 1 of 1 : FA_2015_NA0010_121_6_20151012_00001.jpg

LM Start	0.41	Rating **	M	Issue No.	6
LM End	2.10	Issue Type +	Ma	Location *	WS
Category	Earthen Levee			GPS Latitude/Longitude	
				Start	End
Item	Vegetation			37.106304 °	37.088926 °
				-120.585859 °	-120.566860 °
DWR ID	DWR_NA0010_03_f _ 2015_6				
Action/Comments					
Remove the wild growth other than native grasses from the levee slopes.

Looking at typical view of waterward slope.

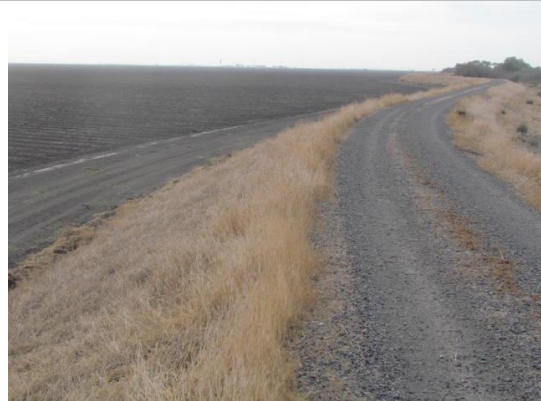
Photo 1 of 1 : FA_2015_NA0010_121_4_20151012_00002.jpg

LM Start	0.41	Rating **	M	Issue No.	4
LM End	2.10	Issue Type +	Ma	Location *	LS
Category	Earthen Levee			GPS Latitude/Longitude	
				Start	End
Item	Vegetation			37.106304 °	37.088924 °
				-120.585859 °	-120.566858 °
DWR ID	DWR_NA0010_03_f _ 2015_4				
Action/Comments					
Remove the wild growth other than native grasses from the levee slopes.

Looking at typical view of landward slope.

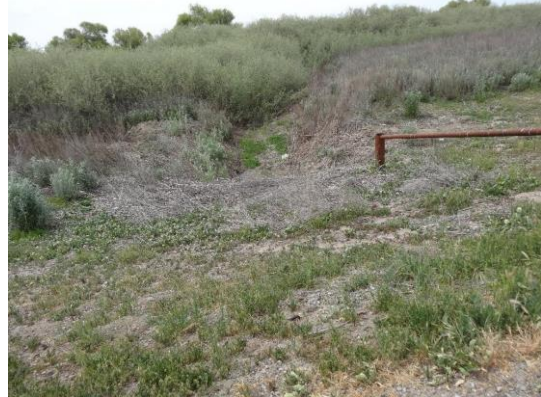
Photo 1 of 3 : UCIP_FA_2015_3521.jpg

Inspector Comments: FS_ID:34083
 DS_ID:19691
 EP_NO: N/A
 FS_HLM: 0.44
 Repair Type: Non-Urgent
 Crossing Status: Found
 UCIP Comments: Need to contact owner. Recommend removing tall grass on landward slope and clearing sediment build up inside pipe.
 FIELD_STRUCT_DESC: 24-inch CM pipe through the levee, 11.3 feet below the crown. Flap gate on the waterward end. (USACE-1967). This entry matches the Drainage or Irrigation Structure referenced in O&M manual (HLM 0.43).
 FS Date: 04/17/2014

View of waterward side.

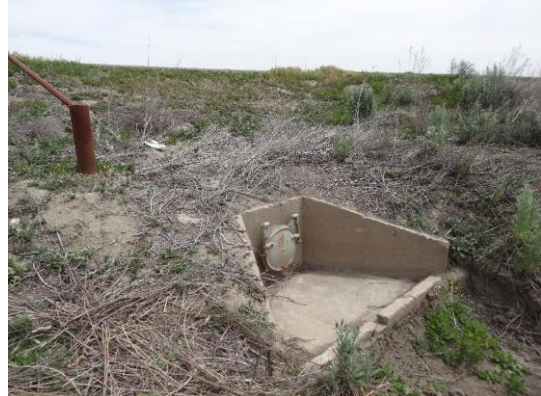
Photo 2 of 3 : UCIP_FA_2015_3522.jpg

Concrete structure and flap gate visible on waterward side.

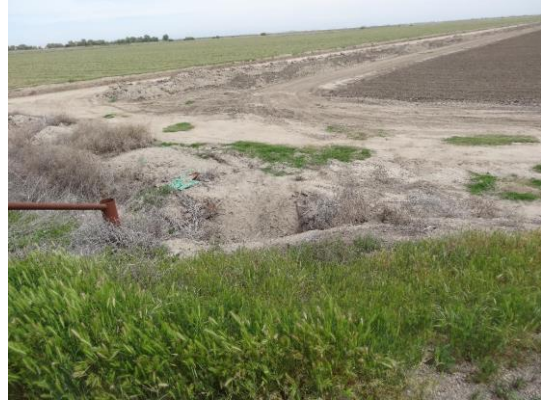
Photo 3 of 3 : UCIP_FA_2015_3523.jpg

LM Start	0.42	Rating **	M	Issue No.	68 (cont)
LM End	0.42	Issue Type +	En	Location *	LS
Category	Supplemental			GPS Latitude/Longitude	
				Start	End
Item	DWR UCIP Field Study			37.106233 °	37.106233 °
				-120.585797 °	-120.585797 °
DWR ID					
Action/Comments					
Inspector Comments: FS_ID:34083 DS_ID:19691 EP_NO: N/A FS_HLM: 0.44 Repair Type: Non-Urgent Crossing Status: Found

View of landward side.

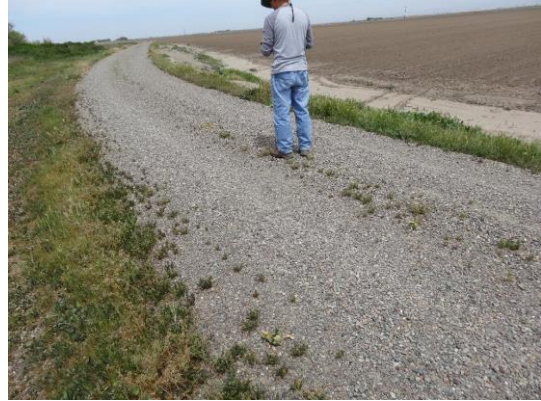
Photo 1 of 3 : UCIP_FA_2015_4774.jpg

Inspector Comments: FS_ID:39371
 DS_ID:19693
 EP_NO: N/A
 FS_HLM: 1.73
 Repair Type: Non-Urgent
 Crossing Status: Found
 UCIP Comments: Sediment buildup in pipe visible from landward side--recommend clearing.
 FIELD_STRUCT_DESC: 24-inch CM pipe through the levee, 6.8 feet below the crown. Flap gate on the waterward end. (USACE-1967). This entry matches the Drainage or Irrigation Structure referenced in O&M manual (HLM 1.72).
 FS Date: 04/17/2014

View of levee crown at crossing.

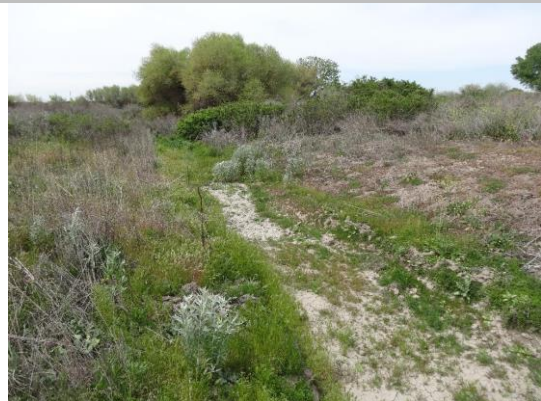
Photo 2 of 3 : UCIP_FA_2015_4775.jpg

View of waterward side--channel.

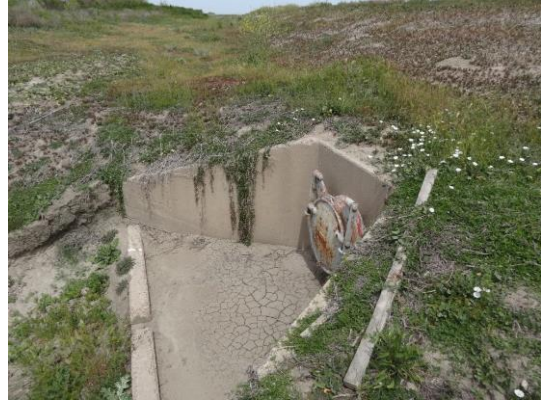
Photo 3 of 3 : UCIP_FA_2015_4776.jpg

LM Start	1.71	Rating **	M	Issue No.	69 (cont)
LM End	1.71	Issue Type +	En	Location *	LS
Category	Supplemental			GPS Latitude/Longitude	
				Start	End
Item	DWR UCIP Field Study			37.092079 °	37.092079 °
				-120.572316 °	-120.572316 °
DWR ID					
Action/Comments					
Inspector Comments: FS_ID:39371					
DS_ID:19693					
EP_NO: N/A					
FS_HLM: 1.73					
Repair Type: Non-Urgent					
Crossing Status: Found

Concrete structure located on waterward side.

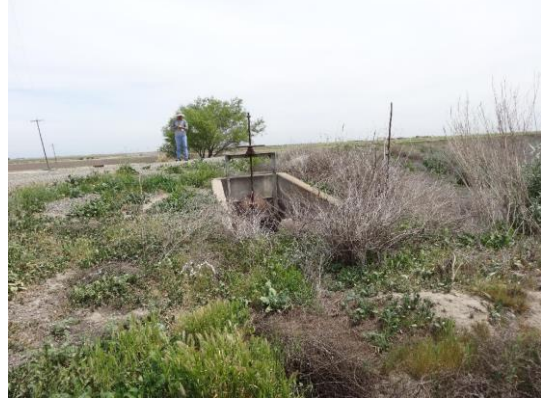
Photo 2 of 3 : UCIP_FA_2015_4799.jpg

Inspector Comments: FS_ID:36543
 DS_ID:19694
 EP_NO: N/A
 FS_HLM: 2.06
 Repair Type: Non-Urgent
 Crossing Status: Found
 UCIP Comments: Need to contact owner--additional appurtenances found on waterward side not part of original description. Unable to determine if walkway, pump, and pipe through waterward berm is if part of original crossing.
 FIELD_STRUCT_DESC: 36-inch CM pipe through the levee, 6.6 feet below the crown. Slide gate on the waterward end. Pump on the waterward bank. (USACE-1967). This entry matches the Drainage or Irrigation Structure referenced in O&M manual (HLM 2.05).
 FS Date: 04/17/2014

Slide gate and concrete structure located on waterward slope.

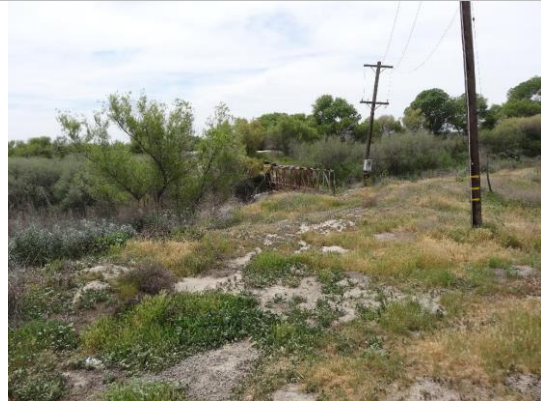
Photo 3 of 3 : UCIP_FA_2015_4800.jpg

View of walkway and berm on waterward side.

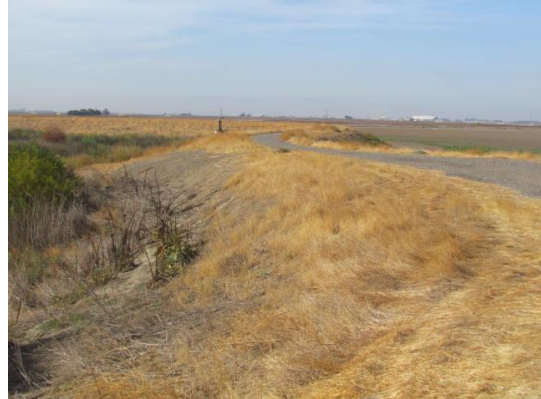
Photo 1 of 1 : FA_2015_NA0010_122_10_20151012_00005.jpg

LM Start	0.01	Rating **	M	Issue No.	10
LM End	1.41	Issue Type +	Ma	Location *	WS
Category	Earthen Levee			GPS Latitude/Longitude	
				Start	End
Item	Vegetation			37.112481 °	°
				-120.589244 °	°
DWR ID	DWR_NA0010_04_f _ 2015_10				
Action/Comments					
Remove the wild growth other than native grasses from the levee slopes.

Looking at typical view of waterward slope.

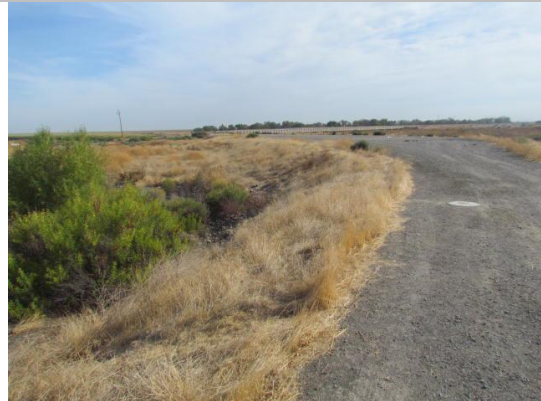
Photo 1 of 1 : FA_2015_NA0010_122_9_20151012_00006.jpg

LM Start	0.01	Rating **	M	Issue No.	9
LM End	1.40	Issue Type +	Ma	Location *	LS
Category	Earthen Levee			GPS Latitude/Longitude	
				Start	End
Item	Vegetation			37.112481 °	°
				-120.589245 °	°
DWR ID	DWR_NA0010_04_f_2015_9				
Action/Comments					
Remove the wild growth other than native grasses from the levee slopes.

Looking at typical view of landward slope.

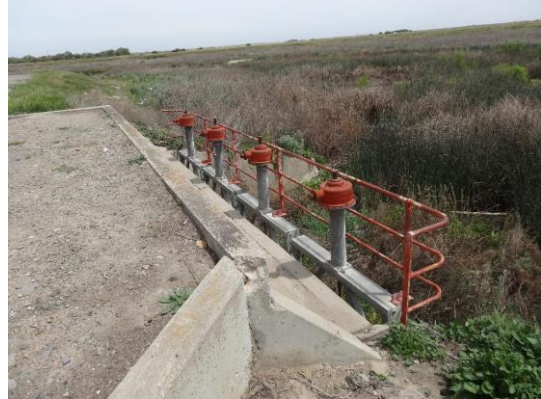
Photo 1 of 3 : UCIP_FA_2015_3568.jpg

Inspector Comments: FS_ID:40529
 DS_ID:19977
 EP_NO: 5024
 FS_HLM: 0.031
 Repair Type: Non-Urgent
 Crossing Status: Found
 UCIP Comments: Slide gates blocked by sediment. Recommend contacting owner to determine status of crossing. Crossing appears to be abandoned.
 FIELD_STRUCT_DESC: [San Joaquin River Diversion Structure] 1 of 4: 72x60-inch R.C.B.C. through the levee, 21.0 feet below the crown.
 Slide gates on the waterward side. Concrete headwalls on both sides.
 Landward slope cobble revetted. Flashboards can be seen on the downstream side of the structure.
 FS Date: 04/17/2014

Concrete headwall located on waterward side.

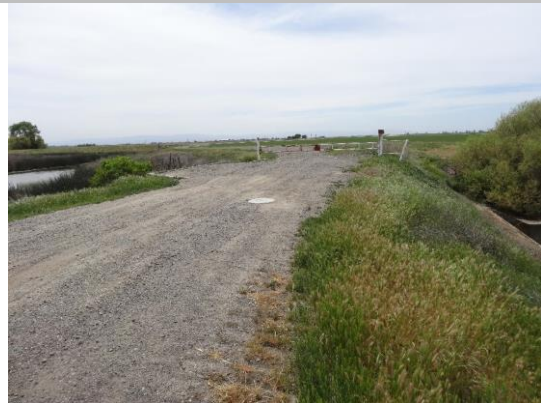
Photo 2 of 3 : UCIP_FA_2015_3569.jpg

View of levee crown.

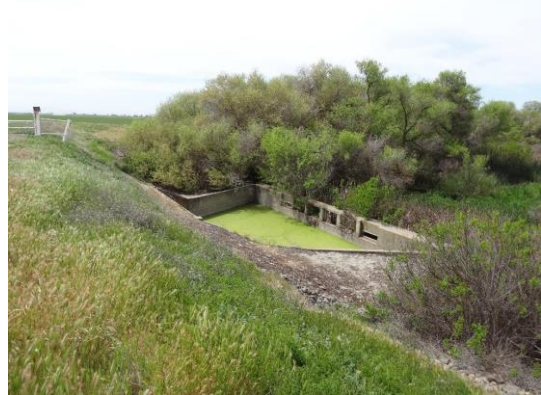
Photo 3 of 3 : UCIP_FA_2015_3570.jpg

LM Start	0.03	Rating **	M	Issue No.	12 (cont)
LM End	0.03	Issue Type +	En	Location *	LS
Category	Supplemental			GPS Latitude/Longitude	
				Start	End
Item	DWR UCIP Field Study			37.112353 °	37.112353 °
				-120.589565 °	-120.589565 °
DWR ID					
Action/Comments					
Inspector Comments: FS_ID:40529 DS_ID:19977 EP_NO: 5024 FS_HLM: 0.031 Repair Type: Non-Urgent Crossing Status: Found

View of concrete structure located on landward side.

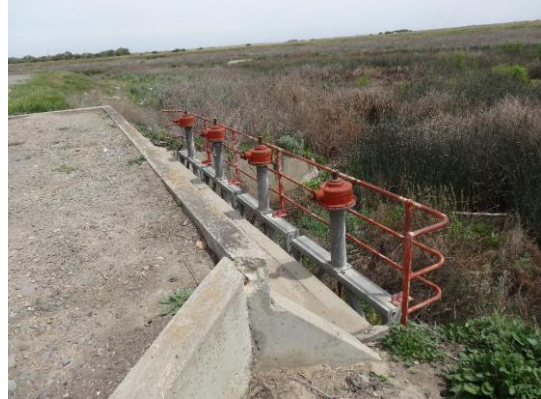
Photo 1 of 3 : UCIP_FA_2015_3741.jpg

LM Start	0.04	Rating **	M	Issue No.	13
LM End	0.04	Issue Type +	En	Location *	LS
Category	Supplemental			GPS Latitude/Longitude	
				Start	End
Item	DWR UCIP Field Study			37.112348 °	37.112348 °
				-120.589581 °	-120.589581 °
DWR ID					
Action/Comments					
Inspector Comments: FS_ID:36875					
DS_ID:24856					
EP_NO: 5024					
FS_HLM: 0.032					
Repair Type: Non-Urgent					
Crossing Status: Found					
UCIP Comments: Slide gates blocked by sediment. Recommend contacting owner to determine status of crossing. Crossing appears to be abandoned.					
FIELD_STRUCT_DESC: [San Joaquin River Diversion Structure] 2 of 4: 72x60-inch R.C.B.C. through the levee, 21.0 feet below the crown. Slide gates on the waterward side. Concrete headwalls on both sides. Landward slope cobble revetted. Flashboards can be seen on the downstream side of the structure.					
FS Date: 04/17/2014

Concrete headwall located on waterward side.

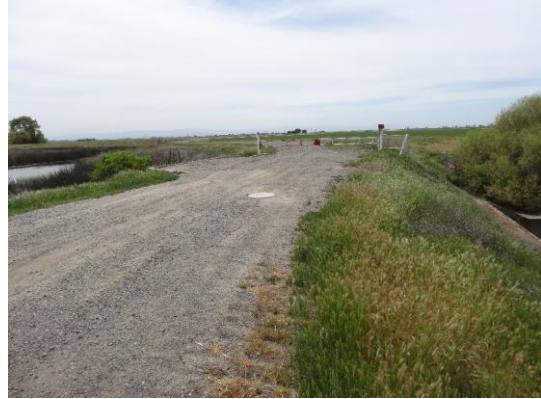
Photo 2 of 3 : UCIP_FA_2015_3742.jpg

Inspector Comments: FS_ID:36875
 DS_ID:24856
 EP_NO: 5024
 FS_HLM: 0.032
 Repair Type: Non-Urgent
 Crossing Status: Found
 UCIP Comments: Slide gates blocked by sediment. Recommend contacting owner to determine status of crossing. Crossing appears to be abandoned.
 FIELD_STRUCT_DESC: [San Joaquin River Diversion Structure] 2 of 4: 72x60-inch R.C.B.C. through the levee, 21.0 feet below the crown. Slide gates on the waterward side. Concrete headwalls on both sides. Landward slope cobble revetted. Flashboards can be seen on the downstream side of the structure.
 FS Date: 04/17/2014

View of levee crown.

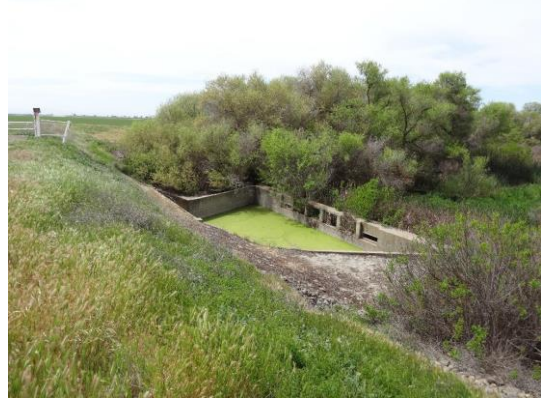
Photo 3 of 3 : UCIP_FA_2015_3743.jpg

View of concrete structure located on landward side.

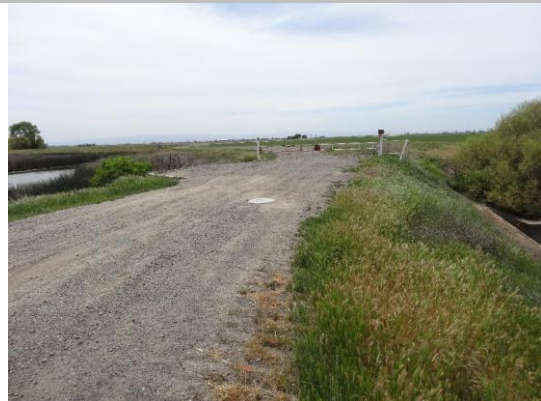
Photo 2 of 3 : UCIP_FA_2015_3754.jpg

View of levee crown.

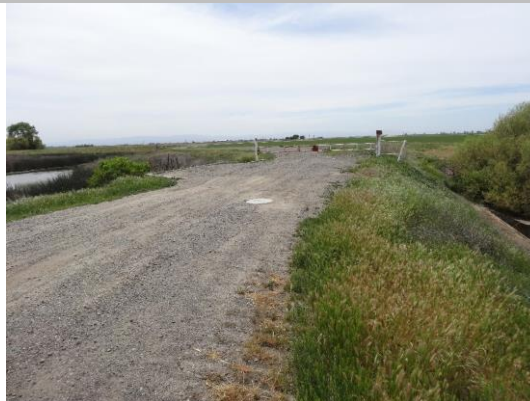
Photo 2 of 3 : UCIP_FA_2015_5295.jpg

Inspector Comments: FS_ID:36877
 DS_ID:24858
 EP_NO: 5024
 FS_HLM: 0.034
 Repair Type: Non-Urgent
 Crossing Status: Found
 UCIP Comments: Slide gates blocked by sediment. Recommend contacting owner to determine status of crossing. Crossing appears to be abandoned.
 FIELD_STRUCT_DESC: [San Joaquin River Diversion Structure] 4 of 4: 72x60-inch R.C.B.C. through the levee, 21.0 feet below the crown. Slide gates on the waterward side. Concrete headwalls on both sides. Landward slope cobble revetted. Flashboards can be seen on the downstream side of the structure.
 FS Date: 04/17/2014

View of levee crown.

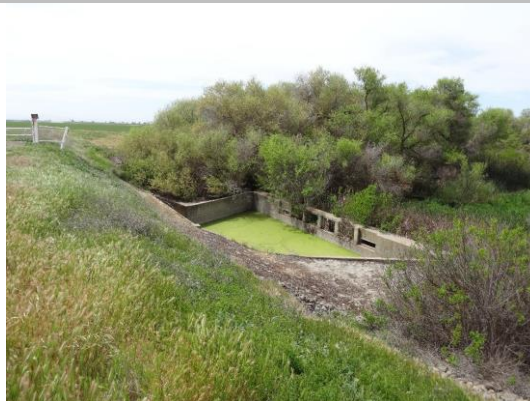
Photo 3 of 3 : UCIP_FA_2015_5296.jpg

View of concrete structure located on landward side.

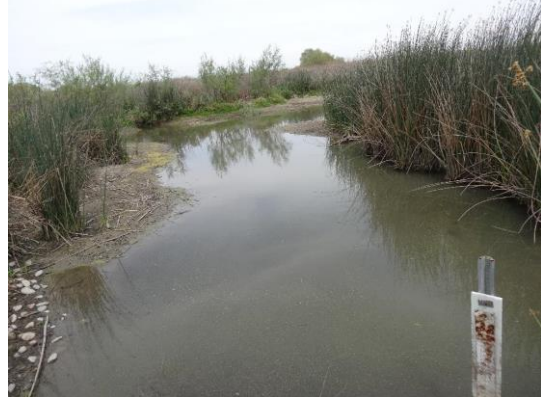
Photo 1 of 3 : UCIP_FA_2015_3571.jpg

View of waterward side.

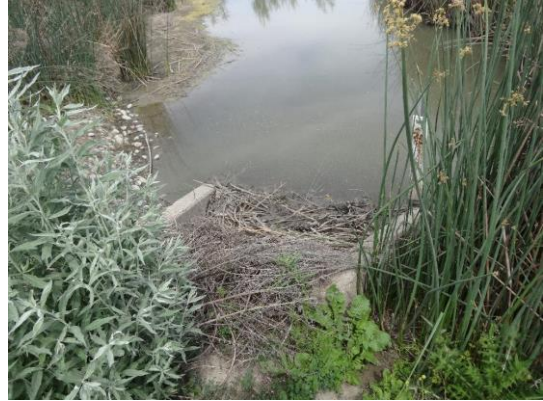
Photo 3 of 3 : UCIP_FA_2015_3644.jpg

View of dense vegetation near concrete headwall located on waterward side.

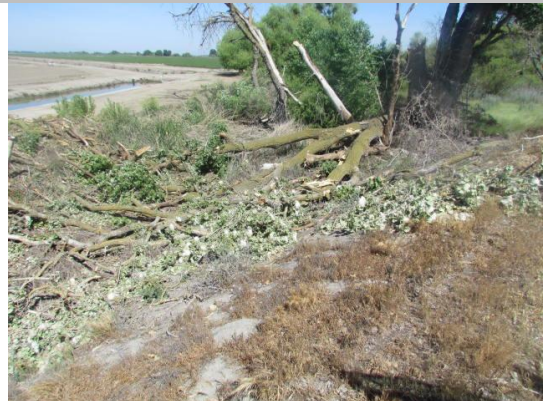
Photo 1 of 1 : FA_2015_NA0010_122_4_20150914_00004.jpg

LM Start	0.30	Rating **	A/W	Issue No.	4
LM End	0.30	Issue Type +	En	Location *	LS
Category	Earthen Levee			GPS Latitude/Longitude	
				Start	End
Item	Encroachments			37.109052 °	37.109052 °
				-120.590800 °	-120.590800 °
DWR ID	DWR_NA0010_04_s_2014_4				
Action/Comments					
Tree or limb					
Inspector Comments: Downed tree on landward slope and toe.

Looking east at downed tree and prunings on landward slope and toe.

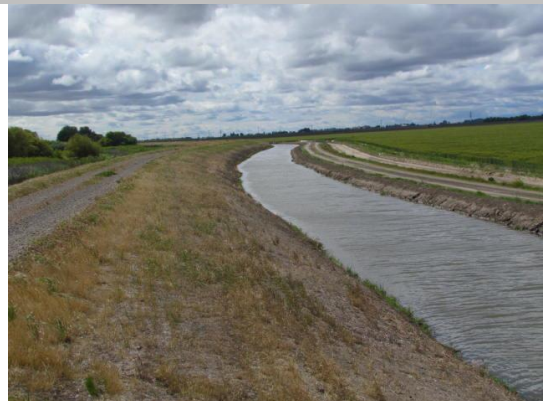
Photo 1 of 3 : FA_2015_NA0010_122_3_20150914_00001.jpg

LM Start	0.32	Rating **	M	Issue No.	3
LM End	1.49	Issue Type +	En	Location *	LS
Category	Earthen Levee			GPS Latitude/Longitude	
				Start	End
Item	Encroachments			37.108822 °	37.096532 °
				-120.590718 °	-120.578027 °
DWR ID	DWR_NA0010_04_s_2012_3				
Action/Comments					
Ditch					
Inspector Comments: Agricultural ditch within 10' easement.

Looking north at irrigation ditch at landside toe.

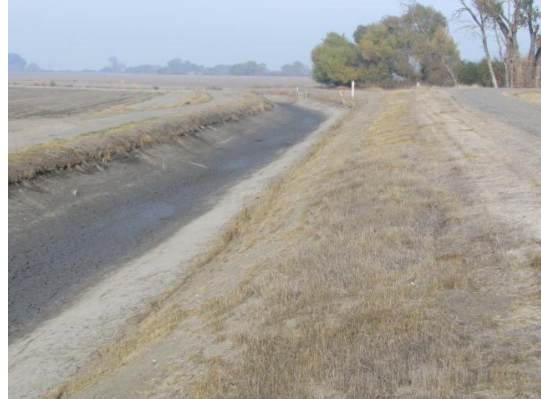
Photo 2 of 3 : FA_2015_NA0010_122_3_20150914_00002.jpg

Looking north at irrigation ditch at landward toe. (Fall 2013)

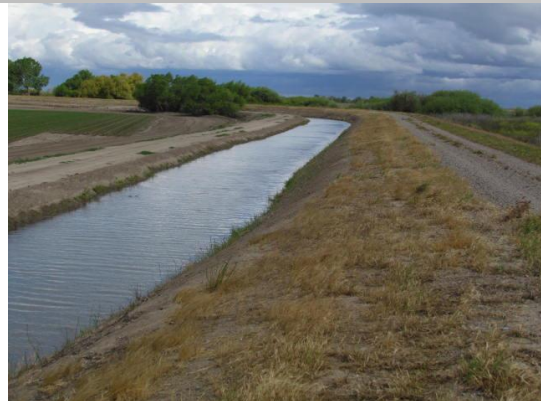
Photo 3 of 3 : FA_2015_NA0010_122_3_20150914_00003.jpg

Looking north at irrigation ditch at landside toe.

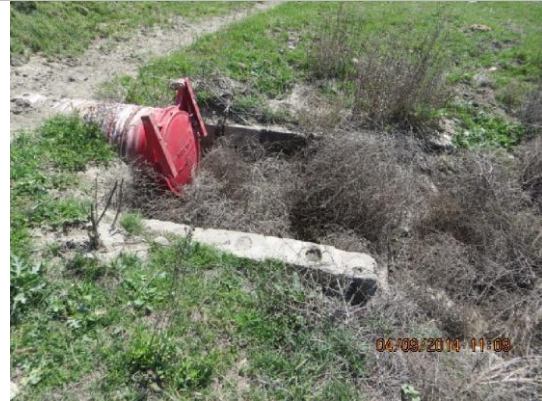
Photo 1 of 3 : UCIP_FA_2015_4423.jpg

Inspector Comments: FS_ID:39563
 DS_ID:19756
 EP_NO: N/A
 FS_HLM: 0.074
 Repair Type: Non-Urgent
 Crossing Status: Found
 UCIP Comments: Debris blocking landward headwall--recommend clearing.
 FIELD_STRUCT_DESC: 24-inch C.M. stormdrain pipe through the levee, 8.6 feet below the crown. Flap gate on the waterward end. Concrete headwall on the landward end. Concrete "U" headwall on the waterward end. (USACE-1967). This entry matches the Drainage or Irrigation Structure referenced in O&M manual (HLM 0.07).
 FS Date: 04/09/2014

Pipe, flapgate, and concrete headwall on WS toe.

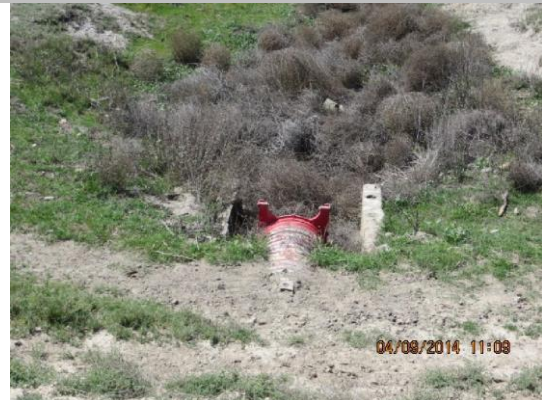
Photo 2 of 3 : UCIP_FA_2015_4424.jpg

Pipe, flapgate, and concrete headwall on WS toe.

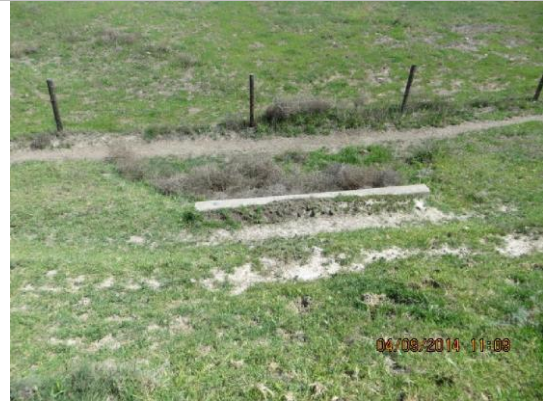
Photo 3 of 3 : UCIP_FA_2015_4425.jpg

Pipe and concrete headwall on LS toe.

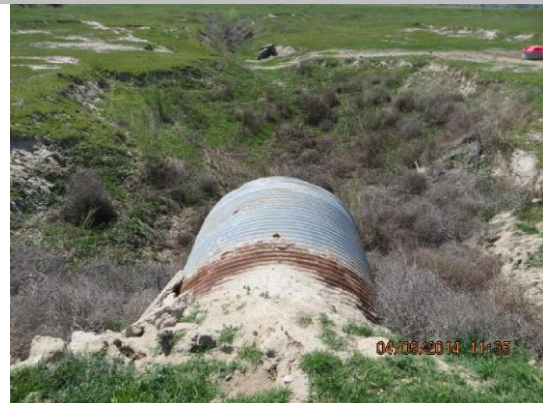
Photo 1 of 3 : UCIP_FA_2015_5498.jpg

LM Start	0.31	Rating **	U	Issue No.	1314
LM End	0.31	Issue Type +	En	Location *	WS
Category	Supplemental			GPS Latitude/Longitude	
				Start	End
Item	DWR UCIP Field Study			37.276669 °	37.276669 °
				-120.819755 °	-120.819755 °
DWR ID					
Action/Comments					
Inspector Comments: FS_ID:39315 DS_ID:24867 EP_NO: N/A FS_HLM: 0.305 Repair Type: Urgent Crossing Status: Found UCIP Comments: Pipe is open on both ends and levee has been degraded at this location. No permit identified for this crossing. FIELD_STRUCT_DESC: 6'X9' CMP stormdrain through the levee 4.5-feet below the crown. Pipe is CMP on WS toe and Steel on the LS toe. The levee is degraded at this location. FS Date: 04/09/2014

Pipe on WS toe.

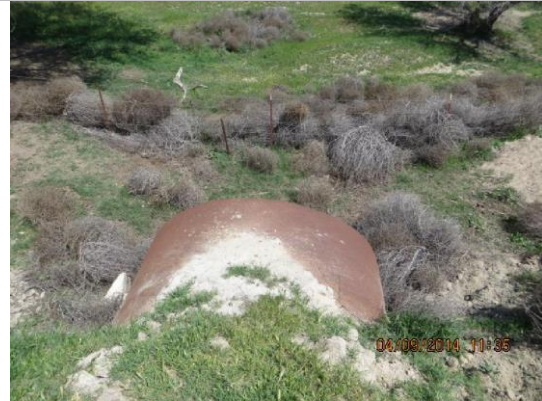
Photo 2 of 3 : UCIP_FA_2015_5499.jpg

Action/Comments					
Inspector Comments: FS_ID:39315 DS_ID:24867 EP_NO: N/A FS_HLM: 0.305 Repair Type: Urgent Crossing Status: Found UCIP Comments: Pipe is open on both ends and levee has been degraded at this location. No permit identified for this crossing. FIELD_STRUCT_DESC: 6'X9' CMP stormdrain through the levee 4.5-feet below the crown. Pipe is CMP on WS toe and Steel on the LS toe. The levee is degraded at this location. FS Date: 04/09/2014

Pipe on LS toe.

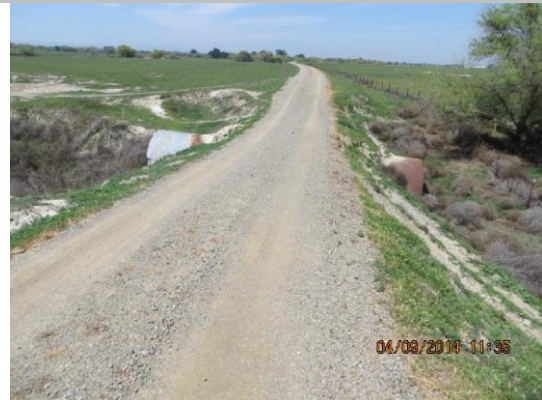
Photo 3 of 3 : UCIP_FA_2015_5500.jpg

Pipe through levee where levee has been degraded.

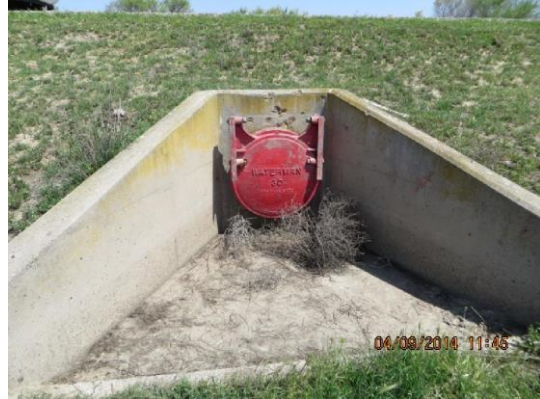
Photo 1 of 3 : UCIP_FA_2015_4426.jpg

LM Start	0.60	Rating **	M	Issue No.	1315
LM End	0.60	Issue Type +	En	Location *	WS
Category	Supplemental			GPS Latitude/Longitude	
				Start	End
Item	DWR UCIP Field Study			37.273945 °	37.273945 °
				-120.815835 °	-120.815835 °
DWR ID					
Action/Comments					
Inspector Comments: FS_ID:39584					
DS_ID:19757					
EP_NO: N/A					
FS_HLM: 0.592					
Repair Type: Non-Urgent					
Crossing Status: Found

Concrete headwall, pipe, and flapgate on WS toe.

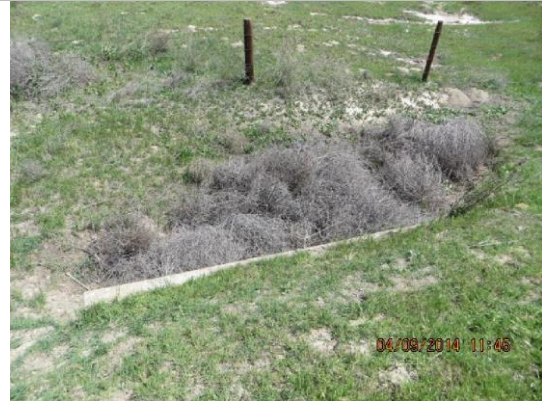
Photo 3 of 3 : UCIP_FA_2015_4432.jpg

Pipe and concrete headwall on LS toe. Note vegetation buildup.

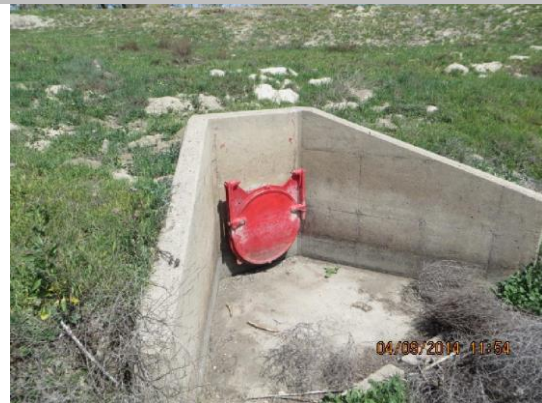
Photo 1 of 3 : UCIP_FA_2015_4433.jpg

LM Start	0.65	Rating **	M	Issue No.	1316
LM End	0.65	Issue Type +	En	Location *	WS
Category	Supplemental			GPS Latitude/Longitude	
				Start	End
Item	DWR UCIP Field Study			37.273398 °	37.273398 °
				-120.815082 °	-120.815082 °
DWR ID					
Action/Comments					
Inspector Comments: FS_ID:39585 DS_ID:19758 EP_NO: N/A FS_HLM: 0.649 Repair Type: Non-Urgent Crossing Status: Found UCIP Comments: Dense vegetation limits the inspector's visibility to identify signs of pipe failure (leaks) along the landward slope. Recommend removing vegetation along pipe alignment to conduct proper inspection of structure. FIELD_STRUCT_DESC: 36-inch C.M. stormdrain pipe through the levee, 13.2 feet below the crown. Flap gate on the waterward end. Concrete headwall on the landward end. Concrete "U" headwall on the waterward end. Cobble revetment around both ends. (USACE-1967). This entry matches the Drainage or Irrigation Structure referenced in O&M manual (HLM 0.65). FS Date: 04/09/2014

Pipe, flapgate, and headwall at WS toe.

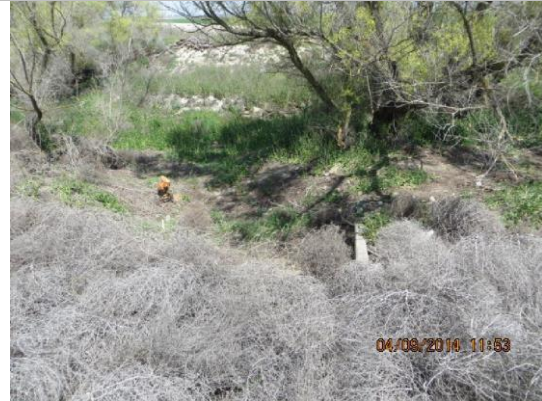
Photo 2 of 3 : UCIP_FA_2015_4434.jpg

Concrete headwall at LS toe.

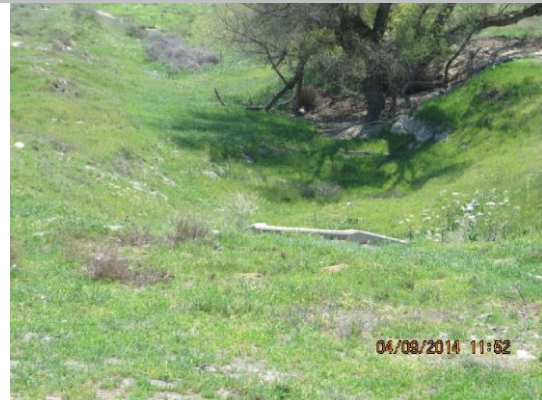
Photo 3 of 3 : UCIP_FA_2015_4435.jpg

Concrete headwall visible off WS toe.

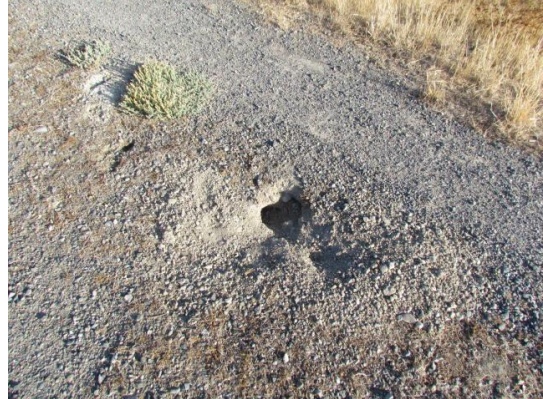
Photo 1 of 1 : FA_2015_NA0010_123_80_20151012_00021.jpg

LM Start	1.50	Rating **	M	Issue No.	80
LM End	1.95	Issue Type +	Ma	Location *	LS
Category	Earthen Levee			GPS Latitude/Longitude	
				Start	End
Item	Animal Control				° 37.260691
					° -120.799397
DWR ID	DWR_NA0010_05_f_2015_80				
Action/Comments					
No rodents visible, but rodent burrows visible; need to backfill and compact or grout burrows. Inspector Comments: Several rodent holes on levee crown within this section.

Looking at typical view of rodent holes within this section on landward slope.

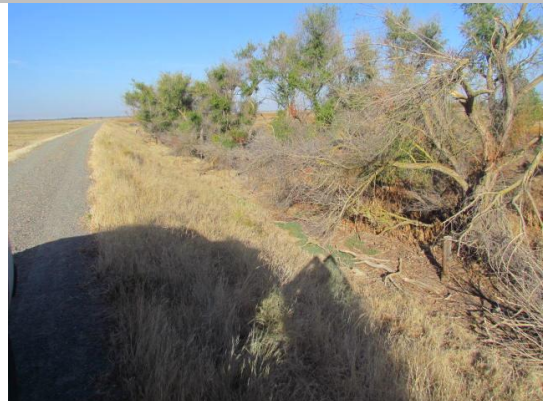
Photo 1 of 1 : FA_2015_NA0010_123_1308_20151012_00022.jpg

LM Start	2.82	Rating **	M	Issue No.	1308
LM End	2.82	Issue Type +	Ma	Location *	LS
Category	Earthen Levee			GPS Latitude/Longitude	
				Start	End
Item	Encroachments			37.256783 °	37.256783 °
				-120.785438 °	-120.785438 °
DWR ID	DWR_NA0010_05_s_2015_1308				
Action/Comments					
Tree or limb					
Inspector Comments: Dead tree limbs at landward toe.

Looking at dead tree limbs on landward toe.

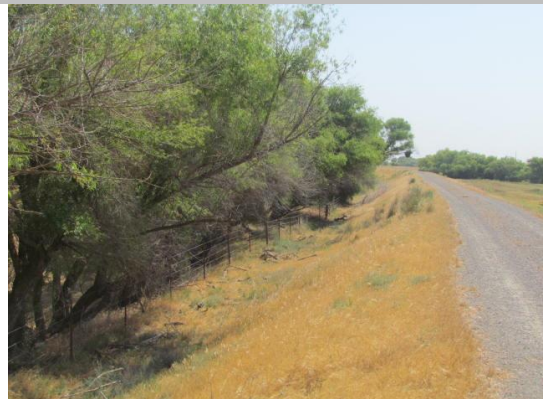
Photo 1 of 1 : FA_2015_NA0010_123_3_20150914_00002.jpg

Looking east at trimmed trees on landward slope and toe.

LM Start	2.82	Rating **	A/W	Issue No.	3
LM End	2.87	Issue Type +	Ma	Location *	LS
Category	Earthen Levee			GPS Latitude/Longitude	
				Start	End
Item	Trim / Thin Trees			37.256803 °	37.256835 °
				-120.785407 °	-120.784528 °
DWR ID	DWR_NA0010_05_s_2012_3				
Action/Comments					
Thin trees to allow visibility of the ground and room to flood fight.

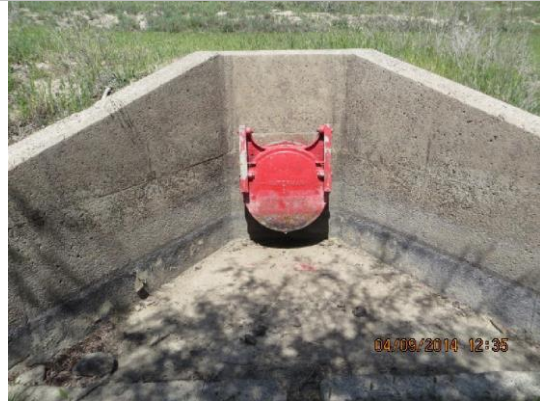
Photo 1 of 3 : UCIP_FA_2015_4436.jpg

Inspector Comments: FS_ID:33709
 DS_ID:19809
 EP_NO: N/A
 FS_HLM: 2.83
 Repair Type: Non-Urgent
 Crossing Status: Found
 UCIP Comments: Log partially blocking inlet at LS toe.
 FIELD_STRUCT_DESC: 24-inch C.M. stormdrain pipe through the levee, 15.0 feet below the crown. Flap gate on the waterward end. Concrete "U" headwalls on both ends. (USACE-1967). This entry matches the Drainage or Irrigation Structure referenced in O&M manual (HLM 2.85).
 FS Date: 04/09/2014

Headwall, pipe, and flapgate on WS toe.

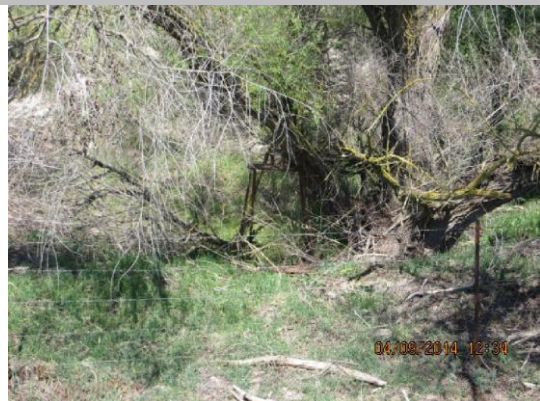
Photo 2 of 3 : UCIP_FA_2015_4437.jpg

Concrete headwall and metal gate hoist on LS toe.
