**Flood Control Project Maintenance
Levee Inspections**

Fall 2015 Levee Maintenance Deficiency Summary Report

San Joaquin River Basin

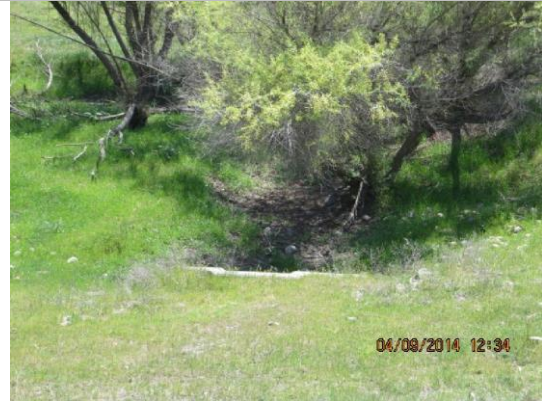
Photo 3 of 3 : UCIP_FA_2015_4438.jpg

Inspector Comments: FS_ID:33709
 DS_ID:19809
 EP_NO: N/A
 FS_HLM: 2.83
 Repair Type: Non-Urgent
 Crossing Status: Found
 UCIP Comments: Log partially blocking inlet at LS toe.
 FIELD_STRUCT_DESC: 24-inch C.M. stormdrain pipe through the levee, 15.0 feet below the crown. Flap gate on the waterward end. Concrete "U" headwalls on both ends. (USACE-1967). This entry matches the Drainage or Irrigation Structure referenced in O&M manual (HLM 2.85).
 FS Date: 04/09/2014

LM Start	2.84	Rating **	M	Issue No.	1317 (cont)
LM End	2.84	Issue Type +	En	Location *	LS
Category	Supplemental			GPS Latitude/Longitude	
				Start	End
Item	DWR UCIP Field Study			37.256810 °	37.256810 °
				-120.785113 °	-120.785113 °
DWR ID					
Action/Comments					
Inspector Comments: FS_ID:33709					
DS_ID:19809					
EP_NO: N/A					
FS_HLM: 2.83					
Repair Type: Non-Urgent					
Crossing Status: Found

Concrete headwall at outlet on WS toe.

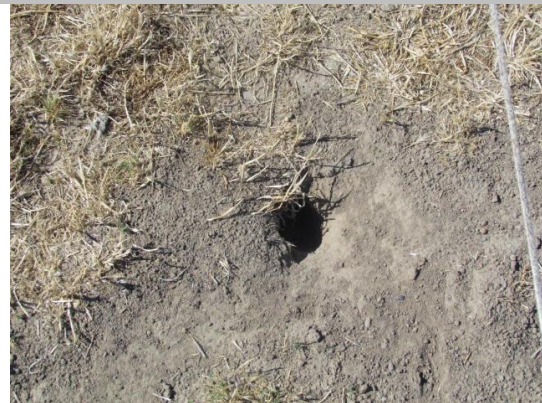
Photo 1 of 1 : FA_2015_NA0010_123_6_20150914_00004.jpg

LM Start	3.20	Rating **	M	Issue No.	6
LM End	3.20	Issue Type +	Ma	Location *	WS
Category	Earthen Levee			GPS Latitude/Longitude	
				Start	End
Item	Animal Control			37.256635 °	37.256635
				-120.778935 °	-120.778935
DWR ID	DWR_NA0010_05_s_2014_6				
Action/Comments					
Exterminate rodents and backfill and compact or grout burrows. Inspector Comments: No rodent visible but several rodent holes visible.

Looking at typical view of rodent holes on waterward slope.

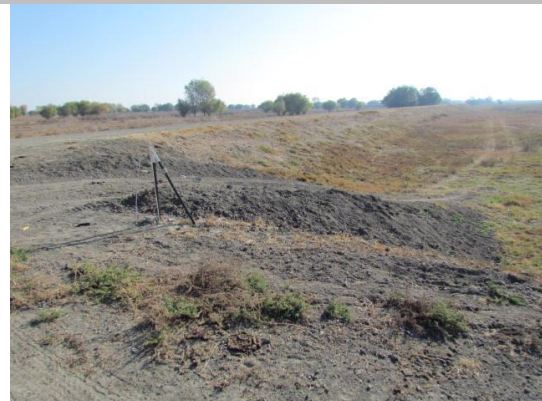
Photo 1 of 3 : FA_2015_NA0010_123_7_20150914_00005.jpg

LM Start	3.20	Rating **	M	Issue No.	7
LM End	3.20	Issue Type +	En	Location *	WS
Category	Earthen Levee			GPS Latitude/Longitude	
				Start	End
Item	Encroachments			37.256554 °	37.256554 °
				-120.778847 °	-120.778847 °
DWR ID	DWR_NA0010_05_f_2012_7				
Action/Comments					
Ramp Inspector Comments: Unauthorized ramp on waterside slope.

Looking south at unauthorized ramp on waterside slope.

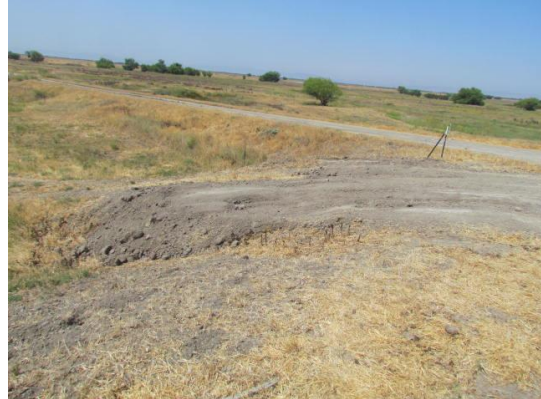
Photo 2 of 3 : FA_2015_NA0010_123_7_20150914_00006.jpg

LM Start	3.20	Rating **	M	Issue No.	7 (cont)
LM End	3.20	Issue Type +	En	Location *	WS
Category	Earthen Levee			GPS Latitude/Longitude	
				Start	End
Item	Encroachments			37.256554 °	37.256554 °
				-120.778847 °	-120.778847 °
DWR ID	DWR_NA0010_05_f _ 2012_7				
Action/Comments					
Ramp					
Inspector Comments: Unauthorized ramp on waterside slope.

Looking northwest at unauthorized ramp on waterward slope.

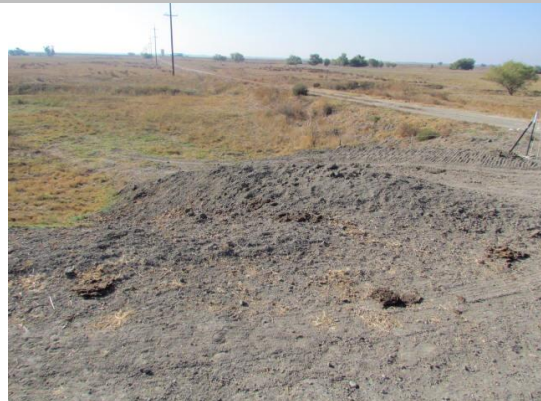
Photo 3 of 3 : FA_2015_NA0010_123_7_20150914_00007.jpg

Looking northwest at unauthorized ramp on waterside slope.

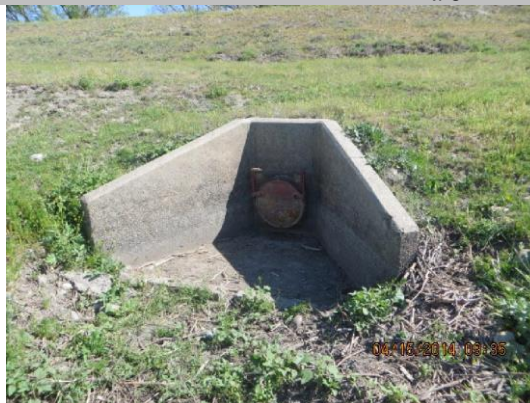
Photo 1 of 3 : UCIP_FA_2015_4439.jpg

Action/Comments					
Inspector Comments: FS_ID:43055 DS_ID:19810 EP_NO: N/A FS_HLM: 3.33 Repair Type: Non-Urgent Crossing Status: Found UCIP Comments: Pipe corroded through at flapgate on WS toe. FIELD_STRUCT_DESC: 24-inch C.M. stormdrain pipe through the levee, 14.7 feet below the crown. Flap gate on the waterward end. Concrete "U" headwalls on both ends. (USACE-1967). This entry matches the Drainage or Irrigation Structure referenced in O&M manual (HLM 3.33). FS Date: 04/15/2014

Flapgate and Concrete headwall at WS toe.

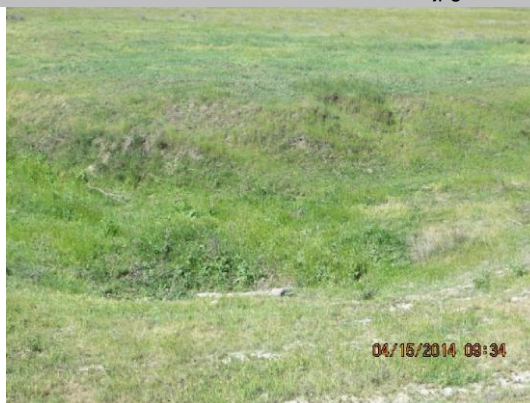
Photo 2 of 3 : UCIP_FA_2015_4440.jpg

Concrete headwall at WS toe.

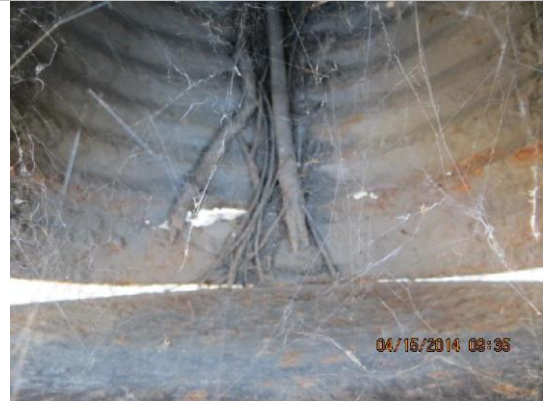
Photo 3 of 3 : UCIP_FA_2015_4441.jpg

LM Start	3.34	Rating **	M	Issue No.	1318 (cont)
LM End	3.34	Issue Type +	En	Location *	LS
Category	Supplemental			GPS Latitude/Longitude	
				Start	End
Item	DWR UCIP Field Study			37.255258 °	37.255258 °
				-120.776996 °	-120.776996 °
DWR ID					
Action/Comments					
Inspector Comments: FS_ID:43055 DS_ID:19810 EP_NO: N/A FS_HLM: 3.33 Repair Type: Non-Urgent Crossing Status: Found

Pipe corroded through just behind flapgate at WS toe.

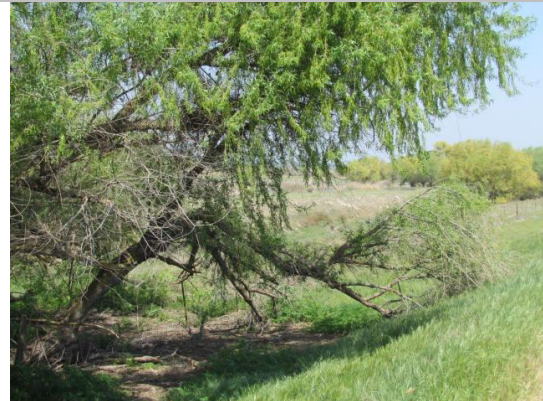
Photo 1 of 1 : FA_2015_NA0010_123_2_20150914_00001.jpg

LM Start	3.55	Rating **	A/W	Issue No.	2
LM End	3.55	Issue Type +	Ma	Location *	LS
Category	Earthen Levee			GPS Latitude/Longitude	
				Start	End
Item	Encroachments			37.255192 °	37.255192 °
				-120.773595 °	-120.773595 °
DWR ID	DWR_NA0010_05_s_2012_2				
Action/Comments					
Tree or limb					
Inspector Comments: Downed tree limb on landside slope and toe.

Looking south at down tree limb on landside slope and toe.

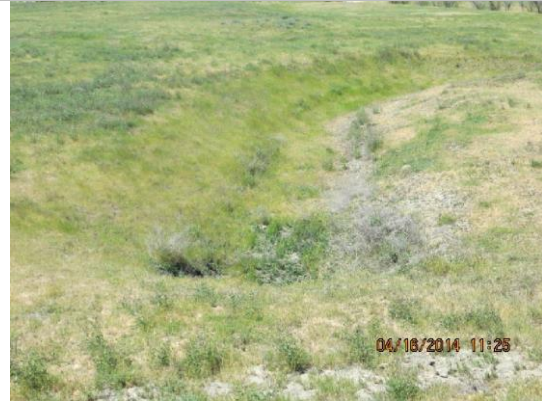
Photo 1 of 3 : UCIP_FA_2015_4003.jpg

Action/Comments					
Inspector Comments: FS_ID:39586 DS_ID:19811 EP_NO: N/A FS_HLM: 3.664 Repair Type: Non-Urgent Crossing Status: Found UCIP Comments: Sediment buildup in pipe visible from landward side--recommend contacting owner to clear pipe. FIELD_STRUCT_DESC: 24-inch C.M. stormdrain pipe through the levee, 15.0 feet below the crown. Flap gate on the waterward end. Concrete headwall on the landward end. Concrete "U" headwall on the waterward end. (USACE-1967). This entry matches the Drainage or Irrigation Structure referenced in O&M manual (HLM 3.67). FS Date: 04/16/2014

Pipe and headwall on LS toe.

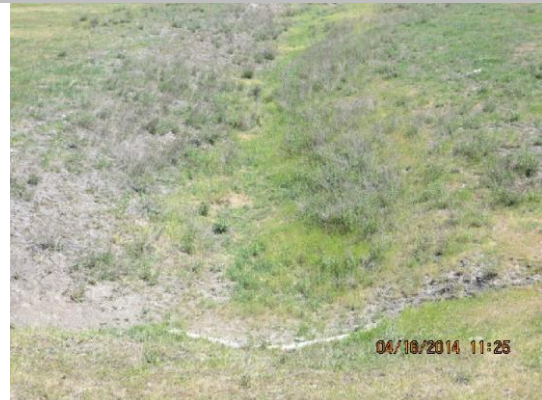
Photo 2 of 3 : UCIP_FA_2015_4004.jpg

Pipe, headwall, and flapgate on WS toe.

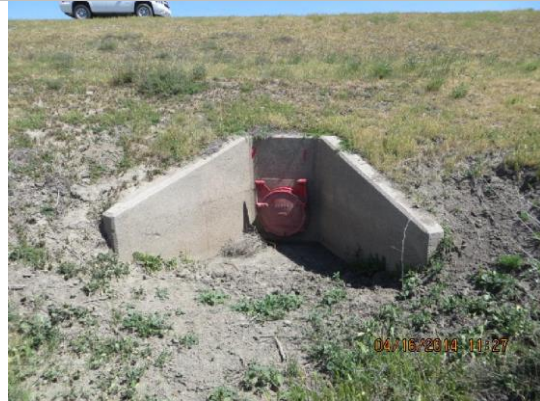
Photo 3 of 3 : UCIP_FA_2015_4005.jpg

LM Start	3.68	Rating **	M	Issue No.	1319 (cont)
LM End	3.68	Issue Type +	En	Location *	LS
Category	Supplemental			GPS Latitude/Longitude	
				Start	End
Item	DWR UCIP Field Study			37.252308 °	37.252308 °
				-120.768038 °	-120.768038 °
DWR ID					
Action/Comments					
Inspector Comments: FS_ID:39586					
DS_ID:19811					
EP_NO: N/A					
FS_HLM: 3.664					
Repair Type: Non-Urgent					
Crossing Status: Found

Pipe, headwall, and flapgate on WS toe.

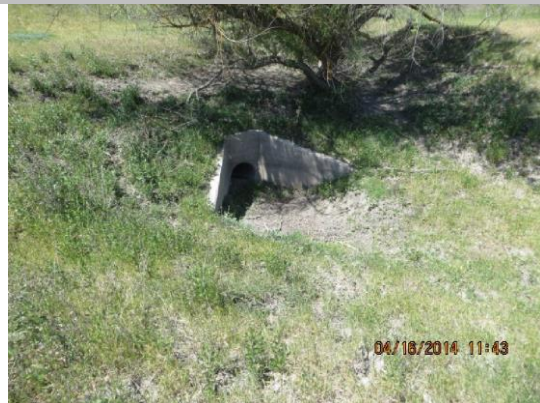
Photo 1 of 3 : UCIP_FA_2015_4006.jpg

LM Start	4.02	Rating **	M	Issue No.	1320
LM End	4.02	Issue Type +	En	Location *	LS
Category	Supplemental			GPS Latitude/Longitude	
				Start	End
Item	DWR UCIP Field Study			37.248432 °	37.248432 °
				-120.764066 °	-120.764066 °
DWR ID					
Action/Comments					
Inspector Comments: FS_ID:39880					
DS_ID:19769					
EP_NO: N/A					
FS_HLM: 4.011					
Repair Type: Non-Urgent					
Crossing Status: Found					
UCIP Comments: Sediment buildup in pipe visible from landward side-- recommend contacting owner to clear pipe.					
FIELD_STRUCT_DESC: 24-inch C.M. stormdrain pipe through the levee, 16.0 feet below the crown. Flap gate on the waterward end. Concrete "U" headwalls on both ends. (USACE-1967). This entry matches the Drainage or Irrigation Structure referenced in O&M manual (HLM 4.02).					
FS Date: 04/16/2014

Pipe and headwall on LS toe.

Inspector Comments: FS_ID:39880
 DS_ID:19769
 EP_NO: N/A
 FS_HLM: 4.011
 Repair Type: Non-Urgent
 Crossing Status: Found
 UCIP Comments: Sediment buildup in pipe visible from landward side--recommend contacting owner to clear pipe.
 FIELD_STRUCT_DESC: 24-inch C.M. stormdrain pipe through the levee, 16.0 feet below the crown. Flap gate on the waterward end.
 Concrete "U" headwalls on both ends. (USACE-1967). This entry matches the Drainage or Irrigation Structure referenced in O&M manual (HLM 4.02).
 FS Date: 04/16/2014

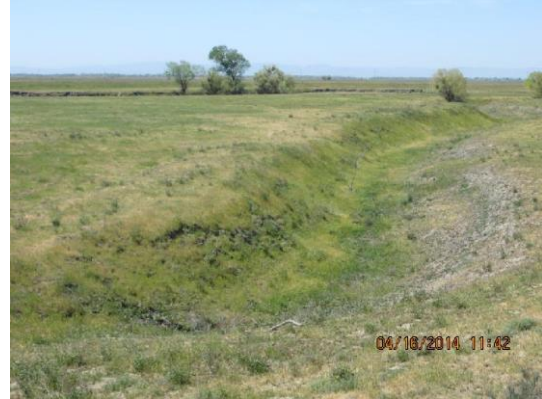
Photo 2 of 3 : UCIP_FA_2015_4007.jpg

Pipe, headwall, and flapgate on WS toe.

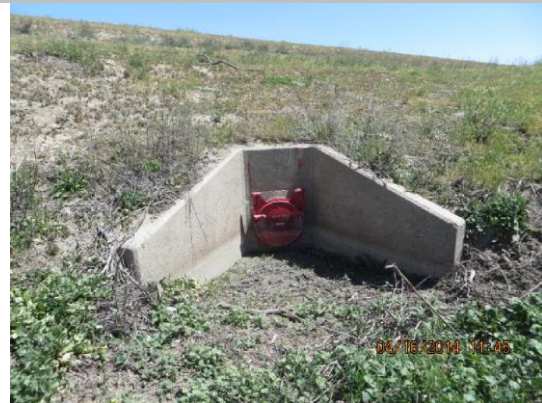
Photo 3 of 3 : UCIP_FA_2015_4139.jpg

Pipe, headwall, and flapgate on WS toe.

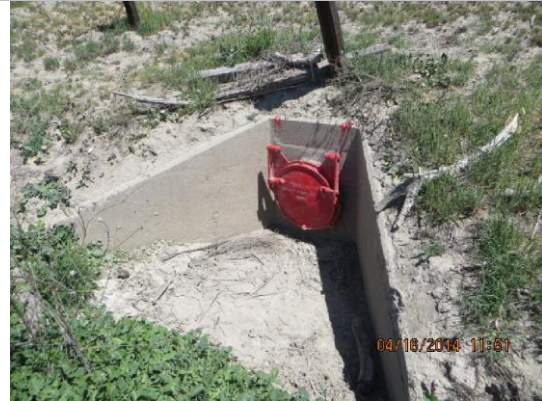
Photo 1 of 3 : UCIP_FA_2015_4140.jpg

LM Start	4.27	Rating **	M	Issue No.	1321
LM End	4.27	Issue Type +	En	Location *	LS
Category	Supplemental			GPS Latitude/Longitude	
				Start	End
Item	DWR UCIP Field Study			37.246008 °	37.246008 °
				-120.760706 °	-120.760706 °
DWR ID					
Action/Comments					
Inspector Comments: FS_ID:39588					
DS_ID:19770					
EP_NO: N/A					
FS_HLM: 4.26					
Repair Type: Non-Urgent					
Crossing Status: Found

Pipe, headwall, and flapgate on WS toe.

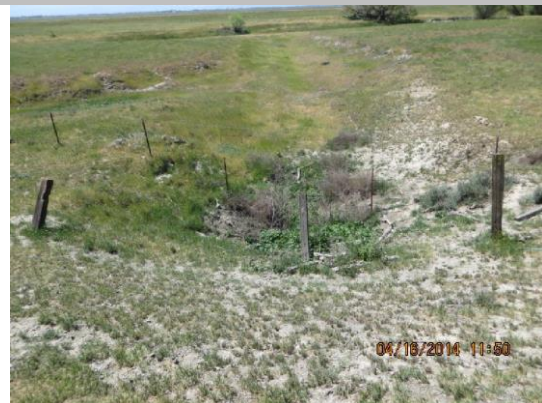
Photo 2 of 3 : UCIP_FA_2015_4141.jpg

Pipe, headwall, and flapgate on WS toe.

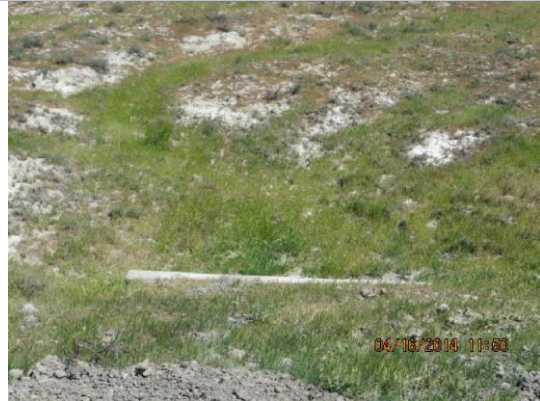
Photo 3 of 3 : UCIP_FA_2015_4182.jpg

LM Start	4.27	Rating **	M	Issue No.	1321 (cont)
LM End	4.27	Issue Type +	En	Location *	LS
Category	Supplemental			GPS Latitude/Longitude	
				Start	End
Item	DWR UCIP Field Study			37.246008 °	37.246008 °
				-120.760706 °	-120.760706 °
DWR ID					
Action/Comments					
Inspector Comments: FS_ID:39588					
DS_ID:19770					
EP_NO: N/A					
FS_HLM: 4.26					
Repair Type: Non-Urgent					
Crossing Status: Found

Concrete headwall and pipe on LS toe.

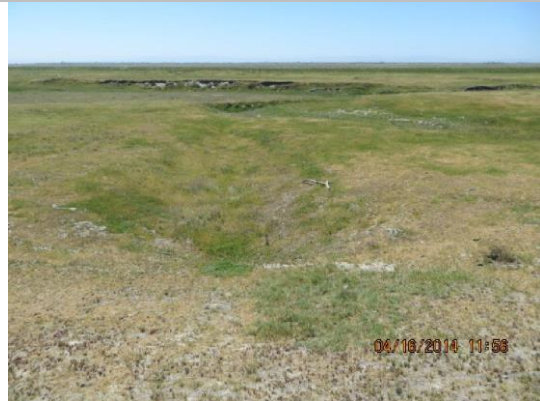
Photo 1 of 3 : UCIP_FA_2015_4083.jpg

LM Start	4.54	Rating **	M	Issue No.	1322
LM End	4.54	Issue Type +	En	Location *	LS
Category	Supplemental			GPS Latitude/Longitude	
				Start	End
Item	DWR UCIP Field Study			37.243668 °	37.243668 °
				-120.756812 °	-120.756812 °
DWR ID					
Action/Comments					
Inspector Comments: FS_ID:39589					
DS_ID:19771					
EP_NO: N/A					
FS_HLM: 4.529					
Repair Type: Non-Urgent					
Crossing Status: Found					
UCIP Comments: Sediment buildup in pipe visible from landward side--recommend contacting owner to clear pipe.					
FIELD_STRUCT_DESC: 24-inch C.M. stormdrain pipe through the levee, 12.0-feet below the crown. Flap gate on the waterward end. Concrete headwall on the landward end. Concrete "U" headwall on the waterward end. (USACE-1967). This entry matches the Drainage or Irrigation Structure referenced in O&M manual (HLM 4.54).					
FS Date: 04/16/2014

Pipe, flapgate, and headwall on WS toe.

Inspector Comments: FS_ID:39589
 DS_ID:19771
 EP_NO: N/A
 FS_HLM: 4.529
 Repair Type: Non-Urgent
 Crossing Status: Found
 UCIP Comments: Sediment buildup in pipe visible from landward side--recommend contacting owner to clear pipe.
 FIELD_STRUCT_DESC: 24-inch C.M. stormdrain pipe through the levee, 12.0-feet below the crown. Flap gate on the waterward end. Concrete headwall on the landward end. Concrete "U" headwall on the waterward end. (USACE-1967). This entry matches the Drainage or Irrigation Structure referenced in O&M manual (HLM 4.54).
 FS Date: 04/16/2014

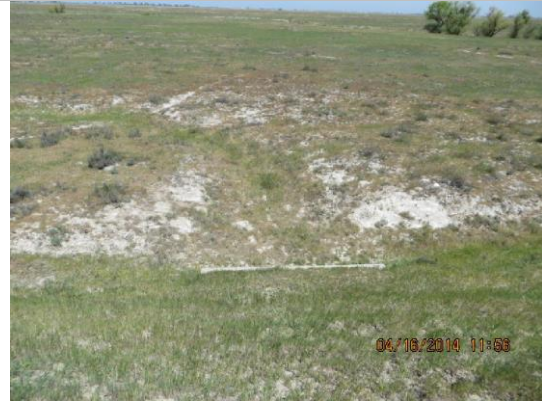
Photo 2 of 3 : UCIP_FA_2015_4084.jpg

Pipe and headwall on LS toe.

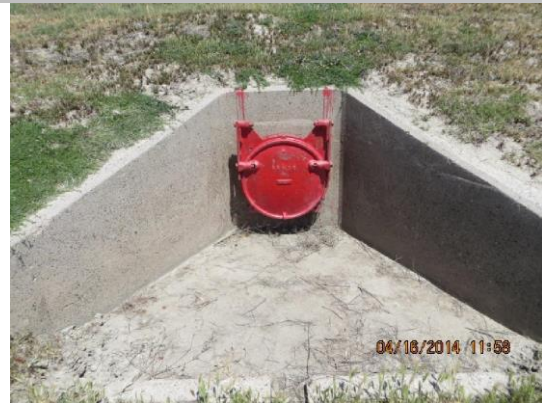
Photo 3 of 3 : UCIP_FA_2015_4085.jpg

Pipe, flapgate, and headwall on WS toe.

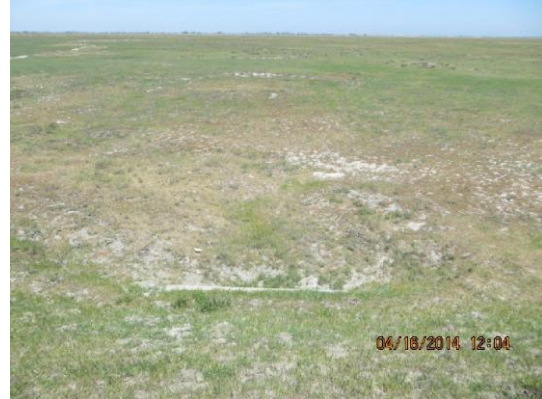
Photo 1 of 3 : UCIP_FA_2015_4086.jpg

LM Start	4.89	Rating **	M	Issue No.	1323
LM End	4.89	Issue Type +	En	Location *	LS
Category	Supplemental			GPS Latitude/Longitude	
				Start	End
Item	DWR UCIP Field Study			37.240978 °	37.240978 °
				-120.751613 °	-120.751613 °
DWR ID					
Action/Comments					
Inspector Comments: FS_ID:39590					
DS_ID:19772					
EP_NO: N/A					
FS_HLM: 4.875					
Repair Type: Non-Urgent					
Crossing Status: Found

Headwall and pipe on LS toe.

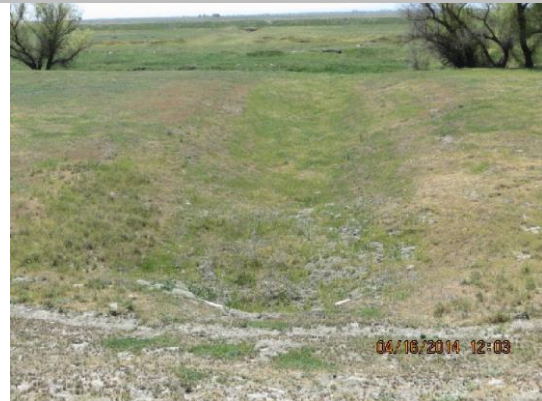
Photo 2 of 3 : UCIP_FA_2015_4087.jpg

Headwall, flapgate, and pipe on WS toe.

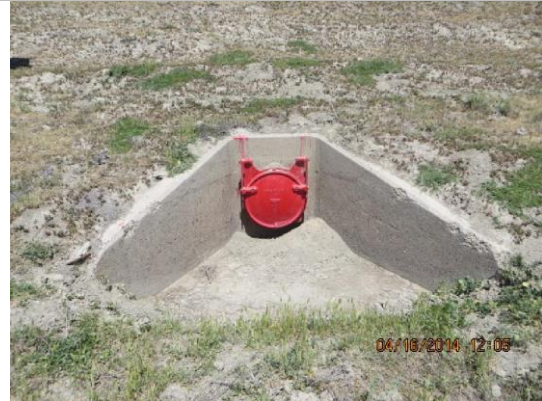
Photo 3 of 3 : UCIP_FA_2015_4088.jpg

LM Start	4.89	Rating **	M	Issue No.	1323 (cont)
LM End	4.89	Issue Type +	En	Location *	LS
Category	Supplemental			GPS Latitude/Longitude	
				Start	End
Item	DWR UCIP Field Study			37.240978 °	37.240978 °
				-120.751613 °	-120.751613 °
DWR ID					
Action/Comments					
Inspector Comments: FS_ID:39590					
DS_ID:19772					
EP_NO: N/A					
FS_HLM: 4.875					
Repair Type: Non-Urgent					
Crossing Status: Found

Headwall, flapgate, and pipe on WS toe.

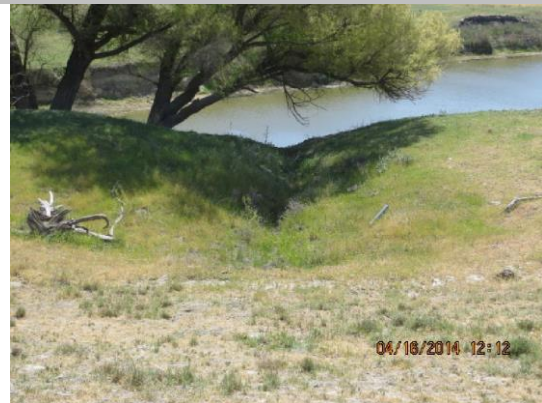
Photo 1 of 3 : UCIP_FA_2015_4089.jpg

LM Start	5.15	Rating **	M	Issue No.	1324
LM End	5.15	Issue Type +	En	Location *	LS
Category	Supplemental			GPS Latitude/Longitude	
				Start	End
Item	DWR UCIP Field Study			37.240607 °	37.240607 °
				-120.746916 °	-120.746916 °
DWR ID					
Action/Comments					
Inspector Comments: FS_ID:39591 DS_ID:19773 EP_NO: N/A FS_HLM: 5.134 Repair Type: Non-Urgent Crossing Status: Found UCIP Comments: Heavy sediment buildup in pipe visible from landward side--recommend contacting owner to clear pipe. FIELD_STRUCT_DESC: 24-inch C.M. stormdrain pipe through the levee, 12.2-feet below the crown. Flap gate on the waterward end. Concrete headwall on the landward end. Concrete "U" headwall on the waterward end. (USACE-1967). This entry matches the Drainage or Irrigation Structure referenced in O&M manual (HLM 5.15). FS Date: 04/16/2014

Headwall, flapgate, and pipe on WS toe.

Inspector Comments: FS_ID:39591
 DS_ID:19773
 EP_NO: N/A
 FS_HLM: 5.134
 Repair Type: Non-Urgent
 Crossing Status: Found
 UCIP Comments: Heavy sediment buildup in pipe visible from landward side--recommend contacting owner to clear pipe.
 FIELD_STRUCT_DESC: 24-inch C.M. stormdrain pipe through the levee, 12.2-feet below the crown. Flap gate on the waterward end. Concrete headwall on the landward end. Concrete "U" headwall on the waterward end. (USACE-1967). This entry matches the Drainage or Irrigation Structure referenced in O&M manual (HLM 5.15).
 FS Date: 04/16/2014

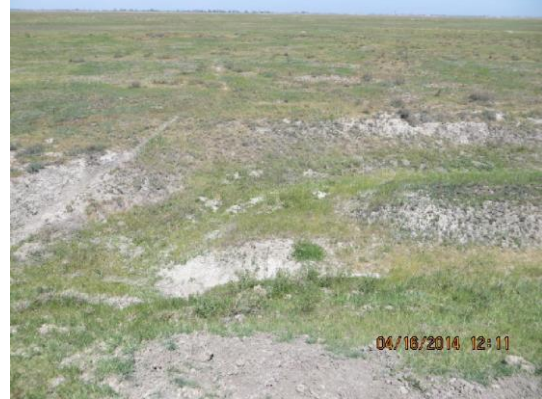
Photo 2 of 3 : UCIP_FA_2015_4090.jpg

Headwall and pipe on LS toe.

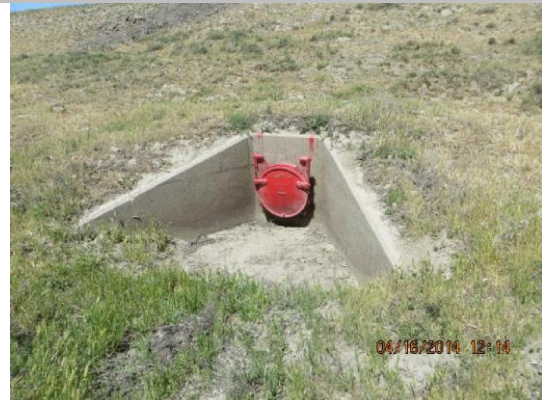
Photo 3 of 3 : UCIP_FA_2015_4091.jpg

Headwall, flapgate, and pipe on WS toe.

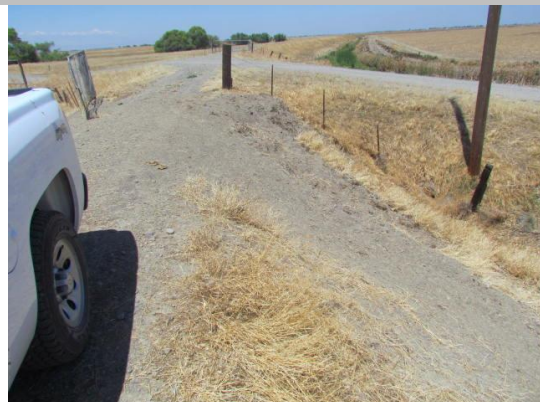
Photo 1 of 2 : FA_2015_NA0010_123_1309_20150914_00017.jpg

LM Start	6.59	Rating **	M	Issue No.	1309
LM End	6.59	Issue Type +	Ma	Location *	LS
Category	Earthen Levee			GPS Latitude/Longitude	
				Start	End
Item	Slope Stability			37.229682 °	37.229682
				-120.726305 °	-120.726305
DWR ID	DWR_NA0010_05_s _ 2015_1309				
Action/Comments					
Repair the levee slope damaged by foot traffic and prevent access where possible.					
Inspector Comments: Landward slope damage caused by animal foot traffic.

Looking north at damaged landward slope.

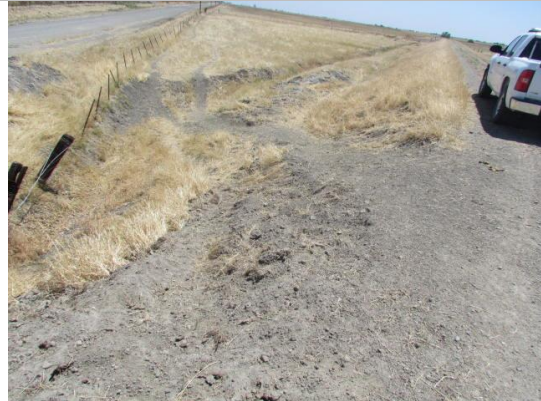
Photo 2 of 2 : FA_2015_NA0010_123_1309_20150914_00018.jpg

LM Start	6.59	Rating **	M	Issue No.	1309 (cont)
LM End	6.59	Issue Type +	Ma	Location *	LS
Category	Earthen Levee			GPS Latitude/Longitude	
				Start	End
Item	Slope Stability			37.229682 °	37.229682 °
				-120.726305 °	-120.726305 °
DWR ID	DWR_NA0010_05_s_2015_1309				
Action/Comments					
Repair the levee slope damaged by foot traffic and prevent access where possible. Inspector Comments: Landward slope damage caused by animal foot traffic.

Looking east at damaged landward slope.

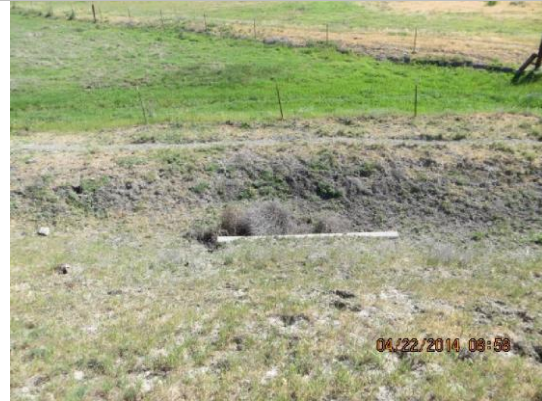
Photo 2 of 3 : UCIP_FA_2015_3612.jpg

Headwall and pipe on LS toe.

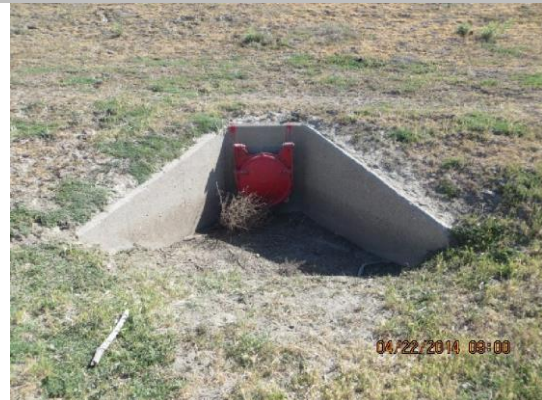
Photo 3 of 3 : UCIP_FA_2015_3613.jpg

Headwall, flapgate, and pipe on WS toe.

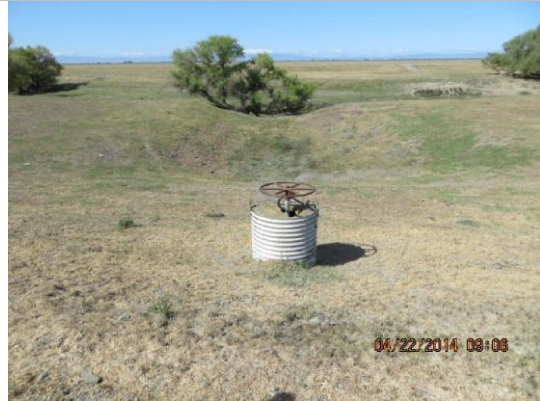
Photo 1 of 2 : UCIP_FA_2015_3614.jpg

Slide gate in CMP riser on WS slope. No outlet or pipe found on WS toe.

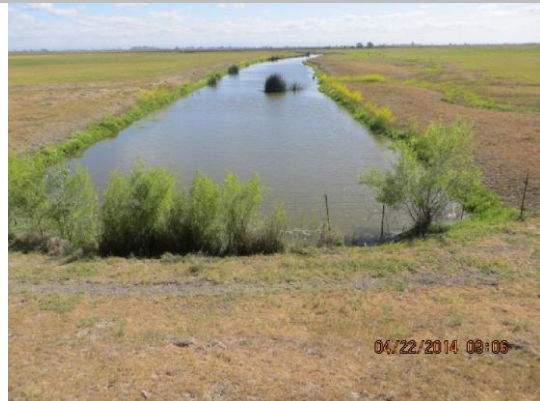
Photo 2 of 2 : UCIP_FA_2015_3615.jpg

Likely inlet on LS toe. No pipe or headwall can be seen at current water level.

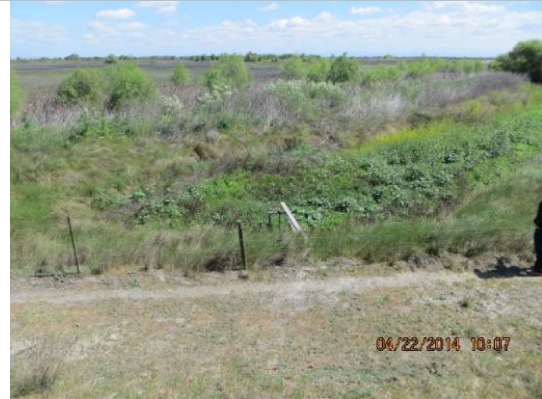
Photo 1 of 3 : UCIP_FA_2015_5469.jpg

Headwall, slidegate, and pipe on LS toe.

Inspector Comments: FS_ID:34265
 DS_ID:19763
 EP_NO: N/A
 FS_HLM: 8.452
 Repair Type: Non-Urgent
 Crossing Status: Found
 UCIP Comments: Pipe filled with silt on LS toe and should be cleared.
 FIELD_STRUCT_DESC: 24-inch CM stormdrain pipe through the levee, 16.0-feet below the crown. Flap gate on the waterward end. Concrete headwall on the landward end. Concrete "U" headwalls on the waterward end. (USACE-1967). This entry matches the Drainage or Irrigation Structure referenced in O&M manual (HLM 8.44).
 FS Date: 04/22/2014

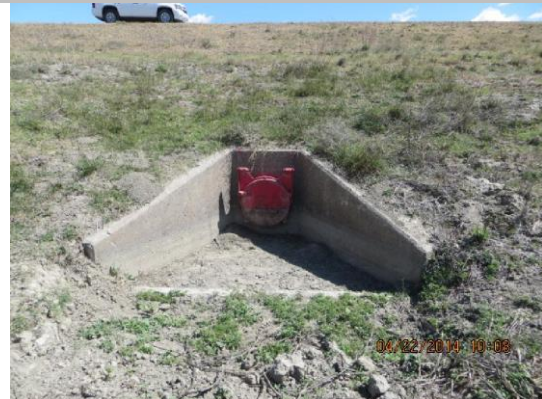
Photo 3 of 3 : UCIP_FA_2015_5471.jpg

Headwall, flapgate, and pipe on WS toe

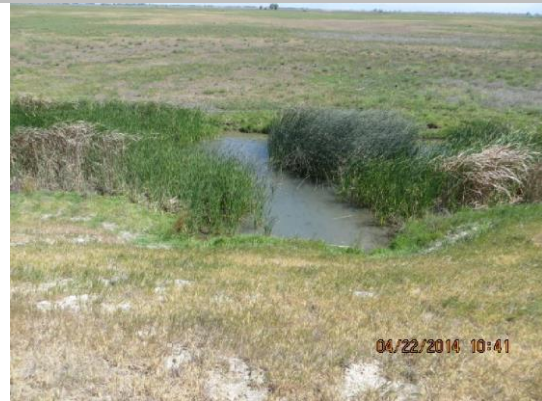
Photo 1 of 3 : UCIP_FA_2015_5537.jpg

Concrete headwall and pipe on LS toe.

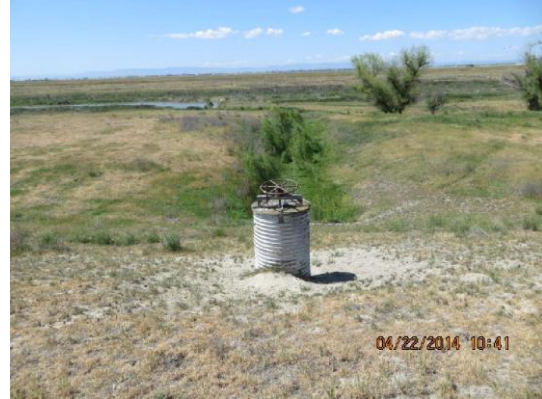
Photo 2 of 3 : UCIP_FA_2015_5538.jpg

Slidegate in CMP riser on WS slope.

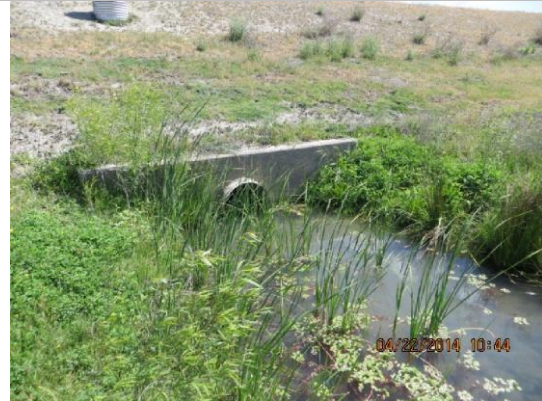
Photo 3 of 3 : UCIP_FA_2015_5539.jpg

Concrete headwall and pipe on WS toe.

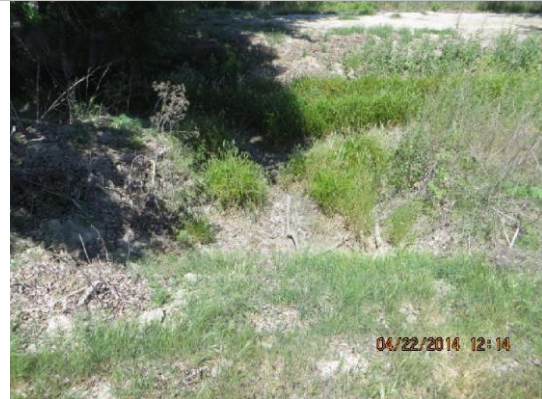
Photo 1 of 3 : UCIP_FA_2015_4393.jpg

Headwall and pipe on LS toe.

Inspector Comments: FS_ID:39593
 DS_ID:19707
 EP_NO: N/A
 FS_HLM: 12.879
 Repair Type: Non-Urgent
 Crossing Status: Found
 UCIP Comments: Sediment buildup in pipe visible from landward side--recommend contacting owner to clear pipe.
 FIELD_STRUCT_DESC: 24-inch CM stormdrain pipe through the levee, 10.2-feet below the crown. Flap gate on the waterward end. Concrete headwalls on the landward end with flashboards. Concrete saddle and apron on the waterward end with a flapgate. Metal screen at LS toe inlet (USACE-1967). This entry matches the Drainage or Irrigation Structure referenced in O&M manual (HLM 12.87).
 FS Date: 04/22/2014

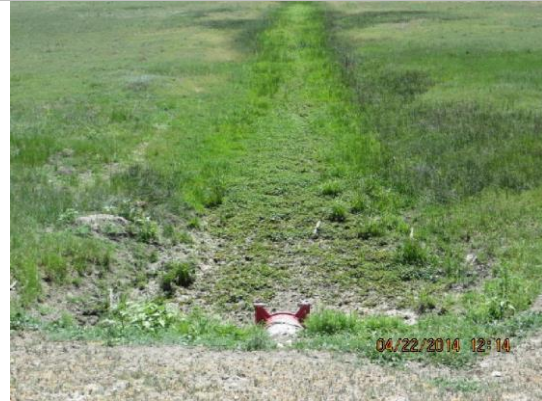
Photo 2 of 3 : UCIP_FA_2015_4394.jpg

Headwall, flapgate, and pipe on WS toe.

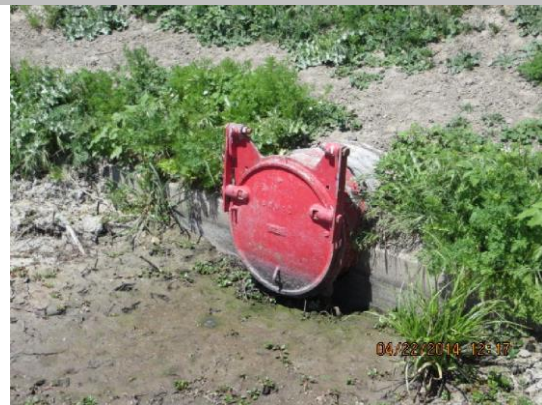
Photo 3 of 3 : UCIP_FA_2015_4395.jpg

Headwall, flapgate, and pipe on WS toe.

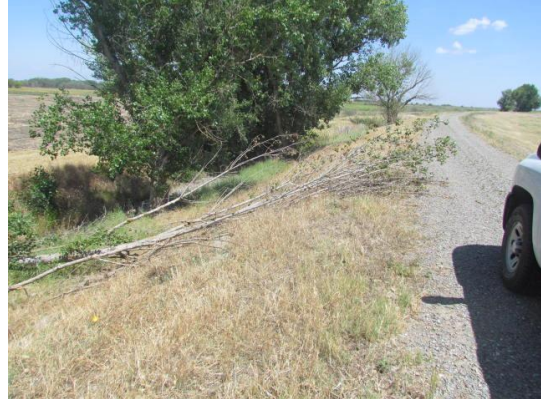
Photo 1 of 1 : FA_2015_NA0010_123_1310_20150914_00019.jpg

LM Start	13.01	Rating **	M	Issue No.	1310
LM End	13.01	Issue Type +	Ma	Location *	LS
Category	Earthen Levee			GPS Latitude/Longitude	
				Start	End
Item	Encroachments			37.175587 °	37.175587 °
				-120.638730 °	-120.638730 °
DWR ID	DWR_NA0010_05_s _ 2015_1310				
Action/Comments					
Tree or limb					
Inspector Comments: Downed tree on landward slope.

Looking east at fallen tree limbs on waterward slope.

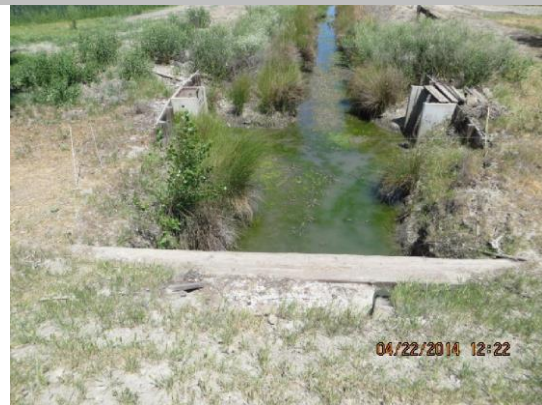
Photo 3 of 3 : UCIP_FA_2015_4398.jpg

Headwall and pipe on LS toe.

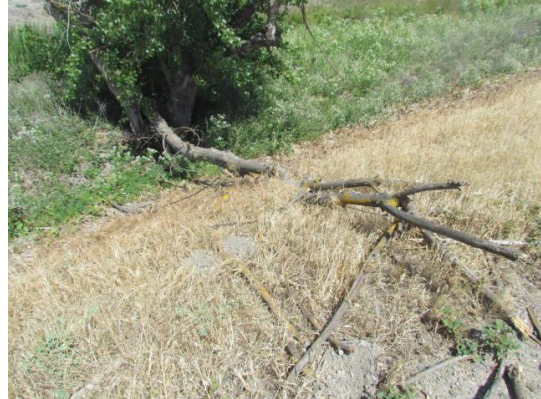
Photo 1 of 1 : FA_2015_NA0010_123_1311_20150914_00020.jpg

LM Start	13.59	Rating **	M	Issue No.	1311
LM End	13.59	Issue Type +	Ma	Location *	LS
Category	Earthen Levee			GPS Latitude/Longitude	
				Start	End
Item	Encroachments			37.169607 °	37.169607 °
				-120.631358 °	-120.631358 °
DWR ID	DWR_NA0010_05_s_2015_1311				
Action/Comments					
Tree or limb					
Inspector Comments: Downed tree on landward slope.

Looking east at a fallen tree limbs on waterward slope.

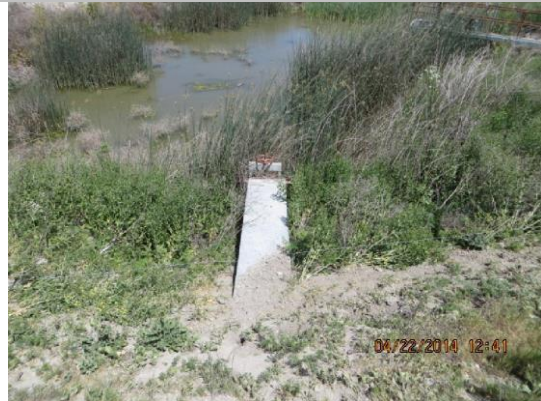
Photo 1 of 2 : UCIP_FA_2015_4100.jpg

Walkway to gatevalve on LS shoulder.

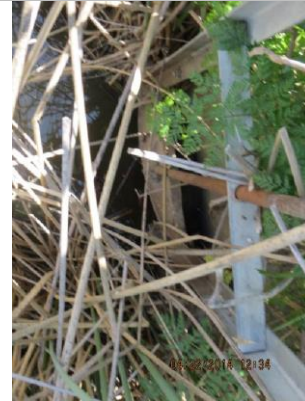
Photo 2 of 2 : UCIP_FA_2015_4101.jpg

Slide gate at concrete headwall on LS toe.

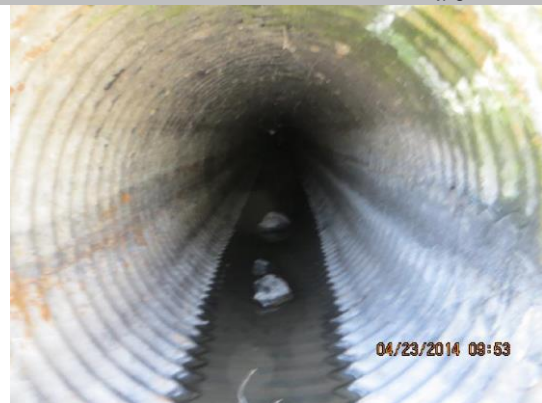
Photo 1 of 3 : UCIP_FA_2015_5655.jpg

Inside pipe at LS toe.

Inspector Comments: FS_ID:34664
 DS_ID:19712
 EP_NO: N/A
 FS_HLM: 15.09
 Repair Type: Non-Urgent
 Crossing Status: Found
 UCIP Comments: Minor erosion at headwall on WS toe.
 FIELD_STRUCT_DESC: 36-inch C.M. stormdrain pipe through the levee, 11.9 feet below the crown. Flap gate on the waterward end. Concrete headwall on both ends. (USACE-1967). This entry matches the Drainage or Irrigation Structure referenced in O&M manual (HLM 15.09).
 FS Date: 04/23/2014

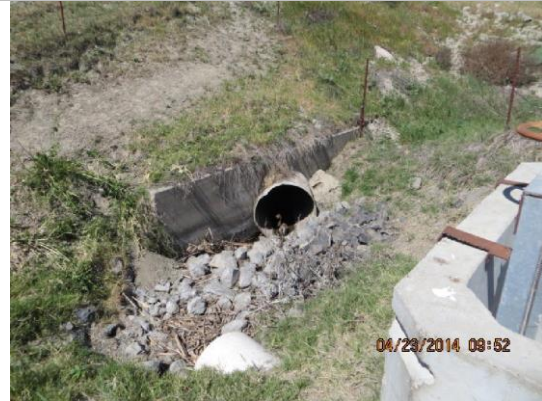
Photo 2 of 3 : UCIP_FA_2015_5656.jpg

Headwall and inlet on LS toe.

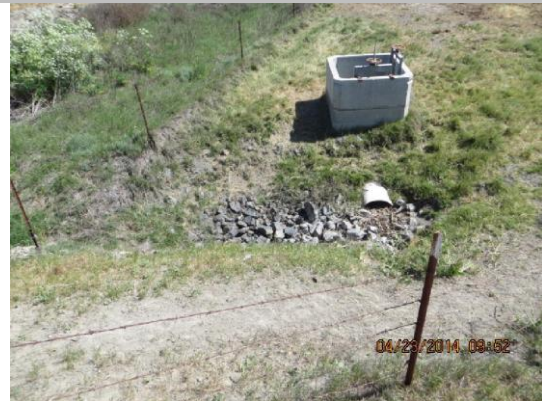
Photo 3 of 3 : UCIP_FA_2015_5657.jpg

Headwall and inlet on LS toe.

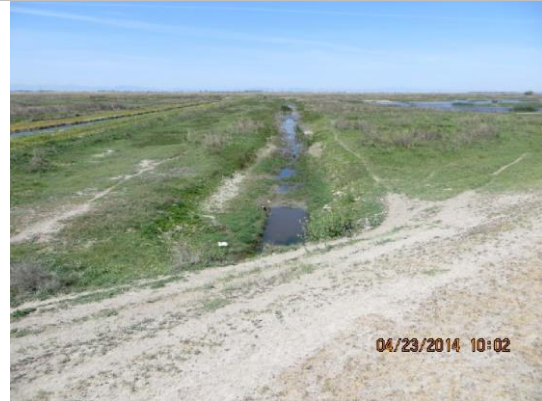
Photo 1 of 3 : UCIP_FA_2015_5658.jpg

Headwall, pipe, and flapgate on WS toe.

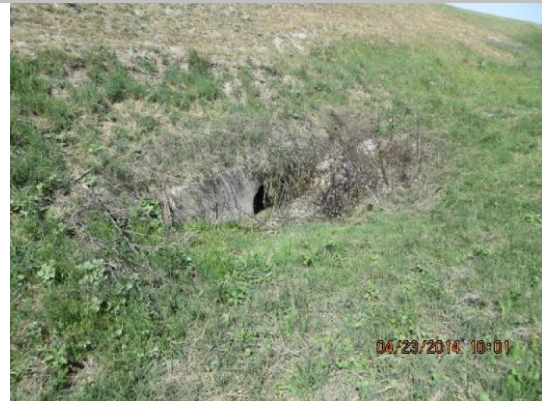
Photo 2 of 3 : UCIP_FA_2015_5659.jpg

Headwall and pipe at LS toe.

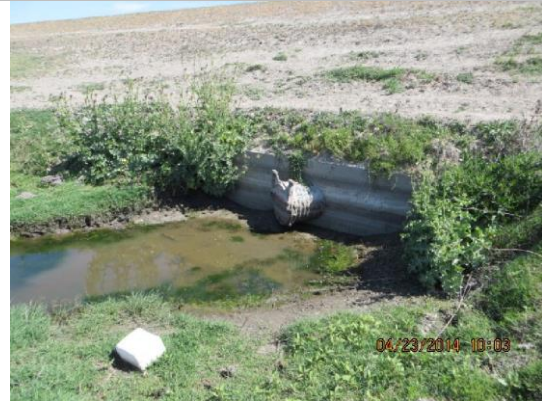
Photo 3 of 3 : UCIP_FA_2015_5660.jpg

Headwall, pipe, and flapgate on WS toe.

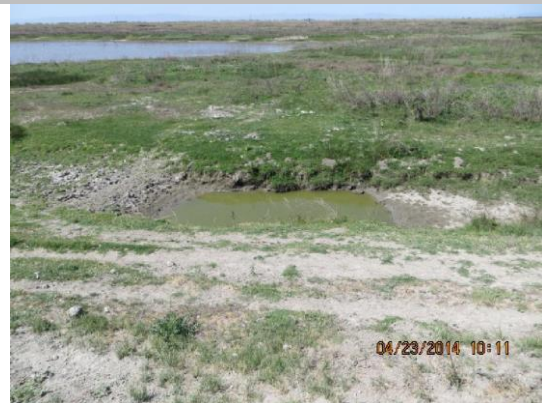
Photo 1 of 3 : UCIP_FA_2015_3600.jpg

LM Start	15.81	Rating **	M	Issue No.	1334
LM End	15.81	Issue Type +	En	Location *	LS
Category	Supplemental			GPS Latitude/Longitude	
				Start	End
Item	DWR UCIP Field Study			37.149381 °	37.149381 °
				-120.600761 °	-120.600761 °
DWR ID					
Action/Comments					
Inspector Comments: FS_ID:39596					
DS_ID:19715					
EP_NO: N/A					
FS_HLM: 15.8					
Repair Type: Non-Urgent					
Crossing Status: Found					
UCIP Comments: Excess vegetation at inlet on LS toe should be cleared.					
FIELD_STRUCT_DESC: 24-inch C.M. stormdrain pipe through the levee, 12-feet below the crown. Flap gate on the waterward end. Concrete head wall on the landward end. Concrete saddle and apron on the waterward end. (USACE-1967). This entry matches the Drainage or Irrigation Structure referenced in O&M manual (HLM 15.80).					
FS Date: 04/23/2014

Headwall, pipe, and flapgate on WS toe.

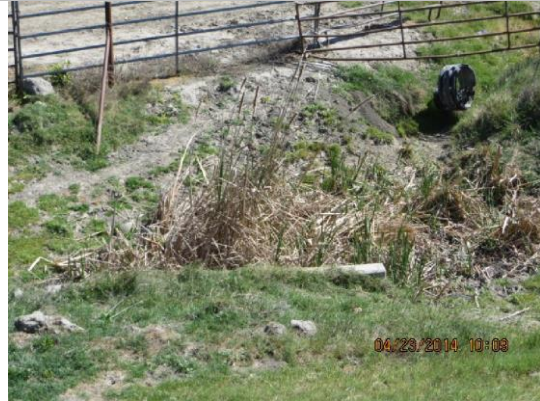
Photo 2 of 3 : UCIP_FA_2015_3601.jpg

Headwall and pipe visible at LS toe.

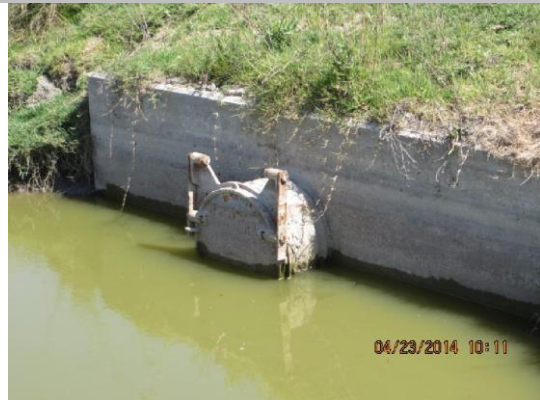
Photo 3 of 3 : UCIP_FA_2015_3602.jpg

Headwall, pipe, and flapgate on WS toe.

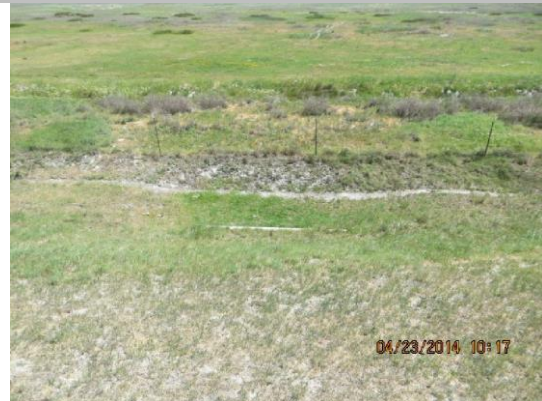
Photo 2 of 3 : UCIP_FA_2015_3604.jpg

Concrete headwall and pipe visible on LS toe.

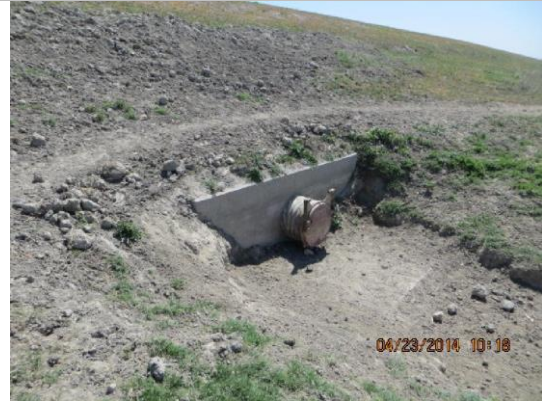
Photo 3 of 3 : UCIP_FA_2015_3605.jpg

Headwall, flapgate, and pipe visible on WS toe.

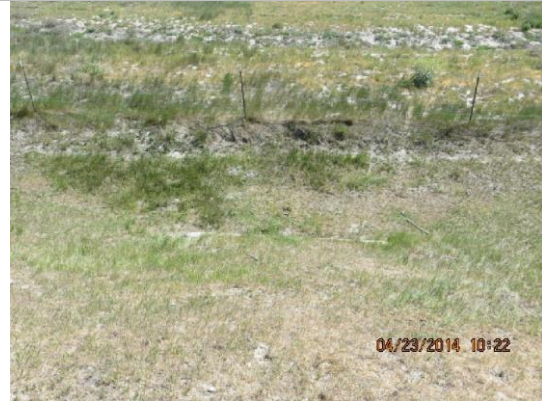
Photo 2 of 3 : UCIP_FA_2015_3607.jpg

Inspector Comments: FS_ID:39597
 DS_ID:19717
 EP_NO: N/A
 FS_HLM: 17.208
 Repair Type: Non-Urgent
 Crossing Status: Found
 UCIP Comments: Sediment buildup in pipe visible from landward side--recommend contacting owner to clear pipe.
 FIELD_STRUCT_DESC: 24-inch CM stormdrain pipe through the levee, 12-feet below the crown. Flap gate on the waterward end. Concrete headwall on both ends. (USACE-1967). This entry matches the Drainage or Irrigation Structure referenced in O&M manual (HLM 17.20).
 FS Date: 04/23/2014

Headwall and pipe visible on LS toe.

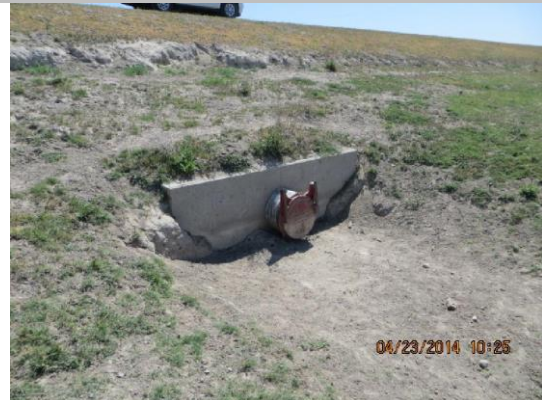
Photo 3 of 3 : UCIP_FA_2015_3608.jpg

Headwall, flapgate, and pipe visible on WS toe.

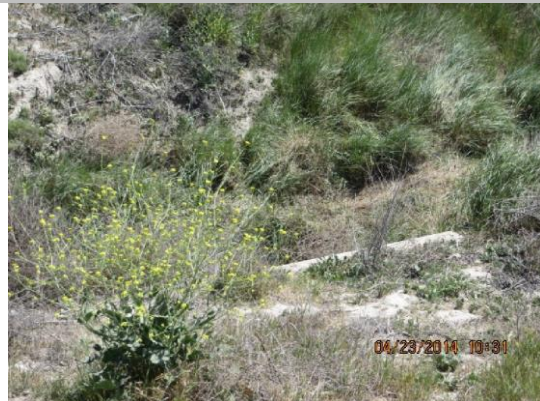
Photo 2 of 2 : UCIP_FA_2015_3610.jpg

Pipe and headwall visible on LS toe.

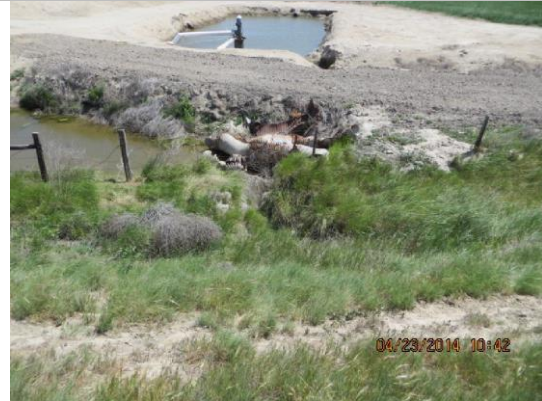
Photo 1 of 3 : UCIP_FA_2015_3633.jpg

Headwall and pipe visible on LS toe.

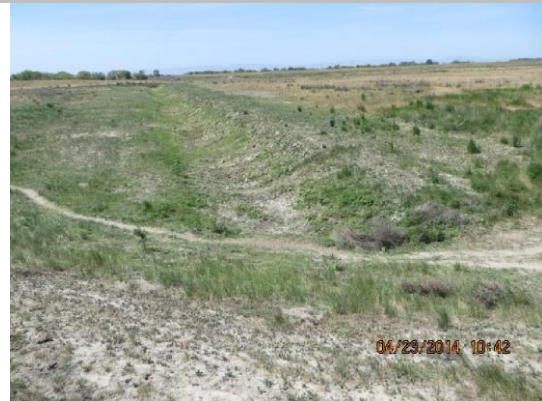
Photo 2 of 3 : UCIP_FA_2015_3634.jpg

Headwall, pipe, and flapgate on WS toe.

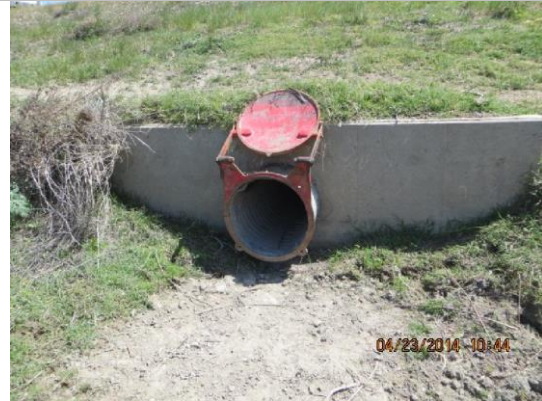
Photo 3 of 3 : UCIP_FA_2015_3635.jpg

Headwall, pipe, and flapgate on WS toe.

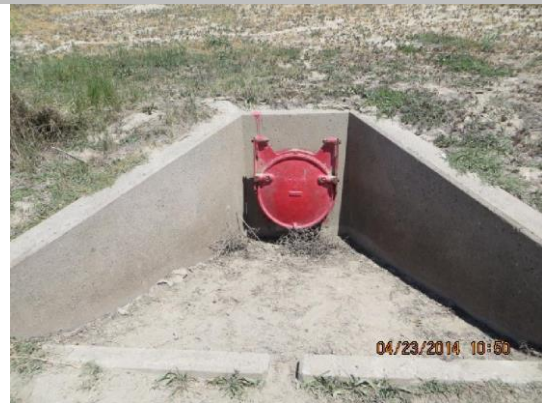
Photo 1 of 3 : UCIP_FA_2015_3636.jpg

Headwall, pipe and flapgate visible on WS toe.

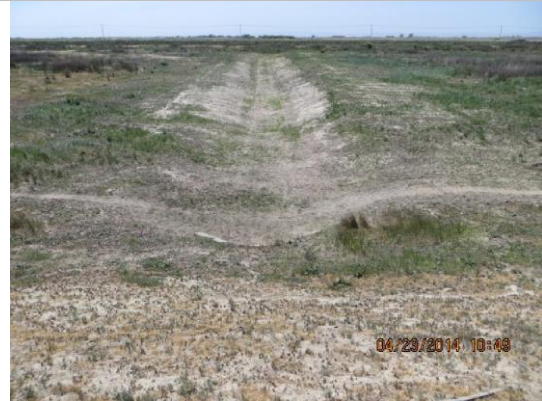
Photo 2 of 3 : UCIP_FA_2015_3637.jpg

Headwall, pipe and flapgate visible on WS toe.

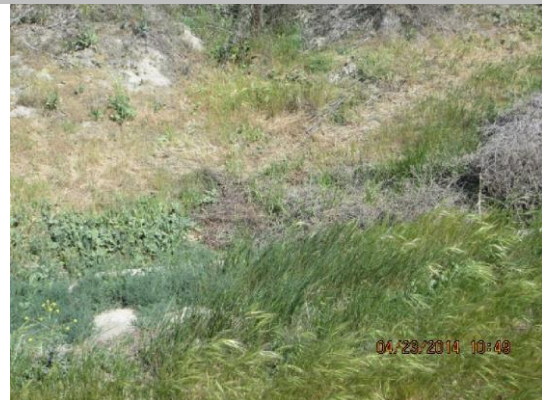
Photo 3 of 3 : UCIP_FA_2015_3638.jpg

Headwall and pipe on LS toe.

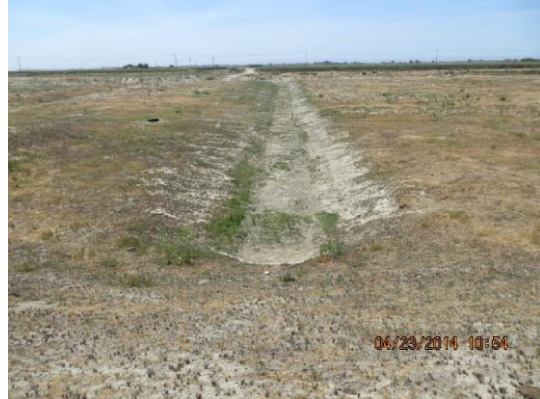
Photo 1 of 3 : UCIP_FA_2015_3639.jpg

Headwall, pipe, and flapgate visible on WS toe.

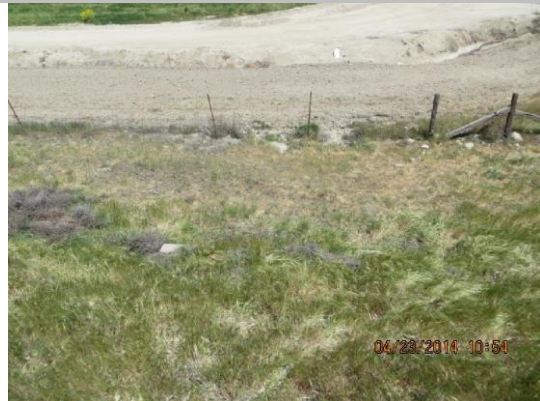
Photo 2 of 3 : UCIP_FA_2015_3640.jpg

Headwall and pipe visible on LS toe.

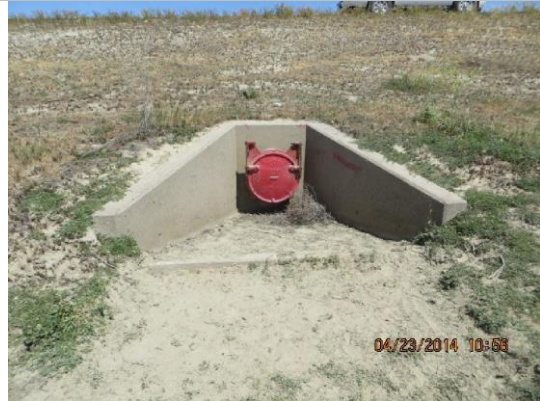
Photo 3 of 3 : UCIP_FA_2015_3641.jpg

Headwall, pipe, and flapgate visible on WS toe.

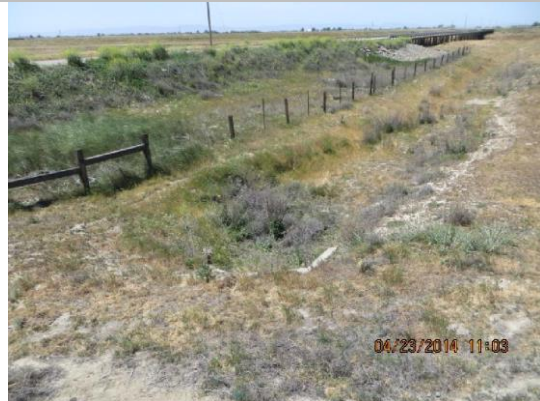
Photo 1 of 3 : UCIP_FA_2015_3813.jpg

Headwall, pipe, and flapgate visible on WS toe.

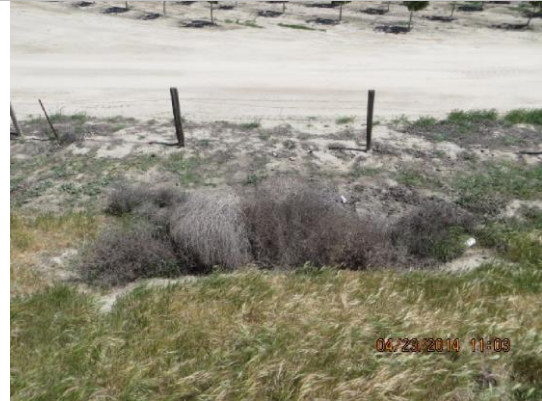
Photo 2 of 3 : UCIP_FA_2015_3814.jpg

Inspector Comments: FS_ID:39602
 DS_ID:19777
 EP_NO: N/A
 FS_HLM: 19.461
 Repair Type: Non-Urgent
 Crossing Status: Found
 UCIP Comments: Sediment buildup in pipe visible from landward side--recommend contacting owner to clear pipe.
 FIELD_STRUCT_DESC: 24-inch C.M. stormdrain pipe through the levee, 9.0-feet below the crown. Flap gate on the waterward end.
 Concrete headwall on the landward end. Concrete "U" headwall on the waterward end. (USACE-1967). This entry matches the Drainage or Irrigation Structure referenced in O&M manual (HLM 19.46).
 FS Date: 04/23/2014

Headwall and pipe visible on LS toe.

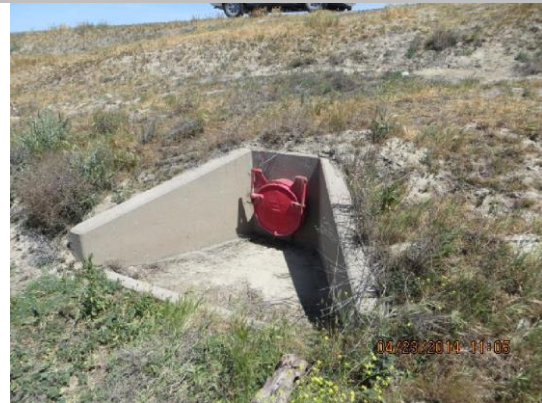
Photo 3 of 3 : UCIP_FA_2015_3815.jpg

Headwall, pipe, and flapgate visible on WS toe.

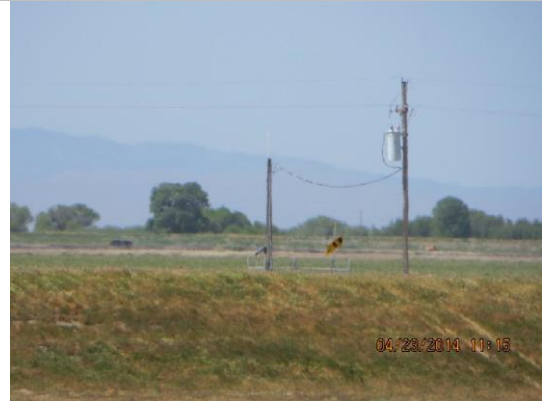
Photo 1 of 2 : UCIP_FA_2015_5501.jpg

Gasline marker off LS of opposite bank.

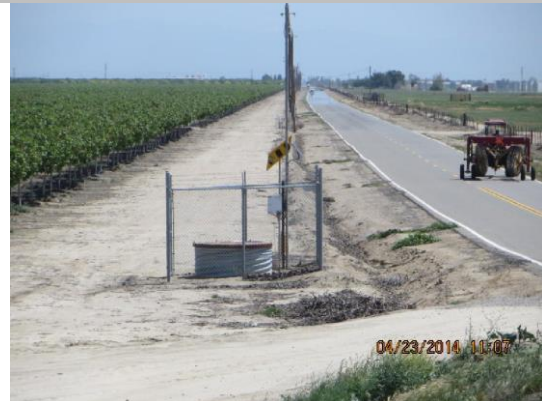
Photo 2 of 2 : UCIP_FA_2015_5502.jpg

Gasline marker off LS toe.

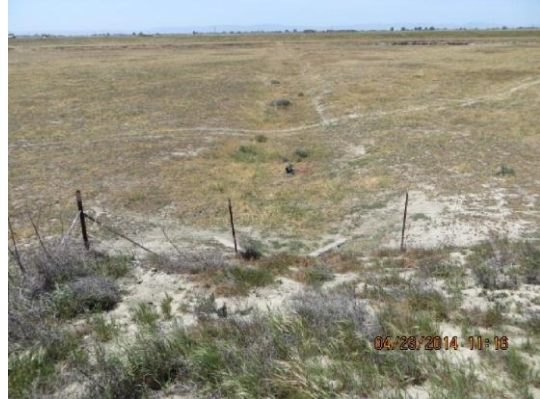
Photo 1 of 3 : UCIP_FA_2015_3816.jpg

Headwall, pipe, and flapgate visible on WS toe.

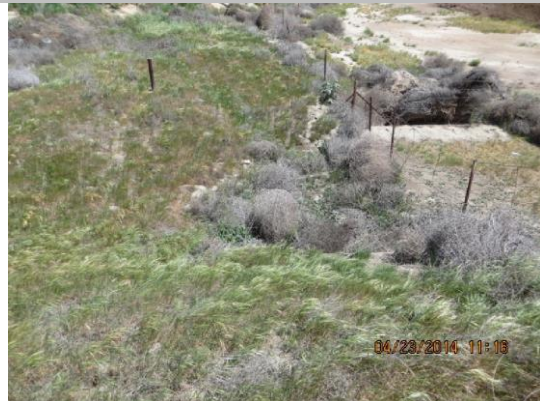
Photo 2 of 3 : UCIP_FA_2015_3817.jpg

Headwall and pipe visible on LS toe.

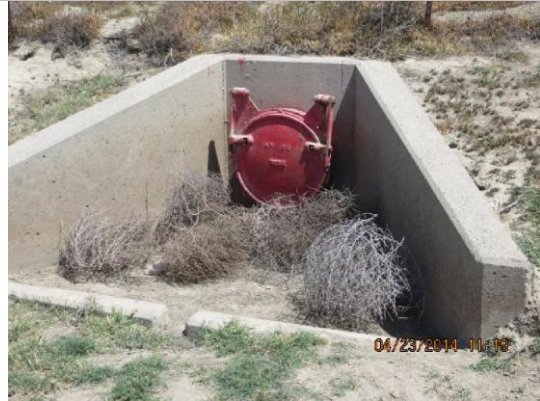
Photo 3 of 3 : UCIP_FA_2015_3818.jpg

Headwall, pipe, and flapgate visible on WS toe.
