**Flood Control Project Maintenance
Levee Inspections**

Fall 2015 Levee Maintenance Deficiency Summary Report

San Joaquin River Basin

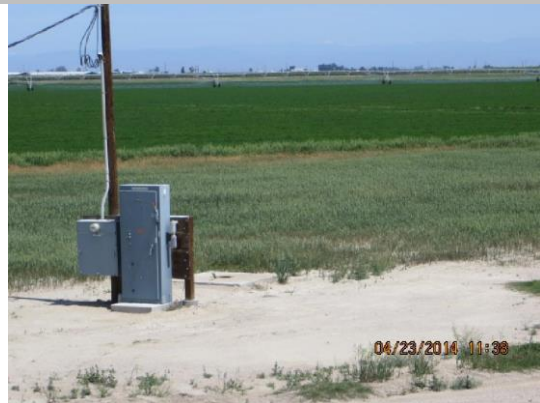
Photo 1 of 1 : UCIP_FA_2015_3840.jpg

Well head visible off LS toe.

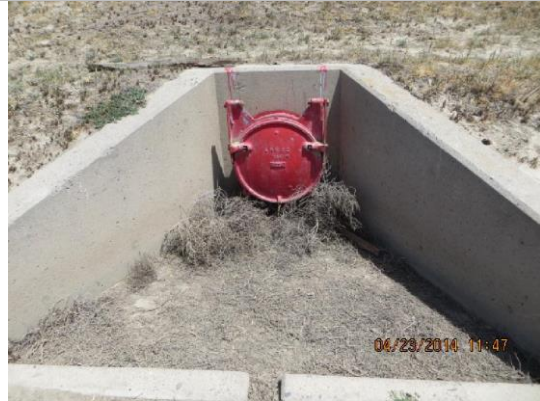
Photo 1 of 3 : UCIP_FA_2015_3841.jpg

Headwall, pipe, and flapgate visible on WS toe.

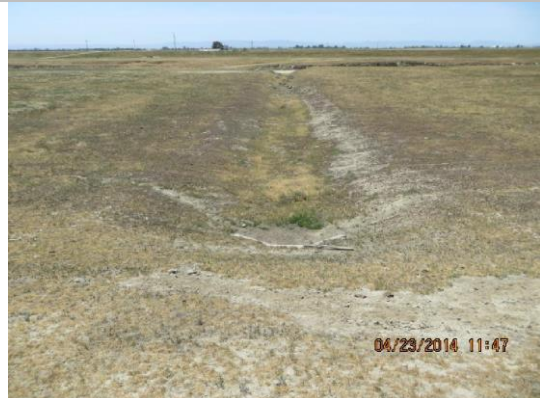
Photo 2 of 3 : UCIP_FA_2015_3842.jpg

Headwall, pipe, and flapgate visible on WS toe.

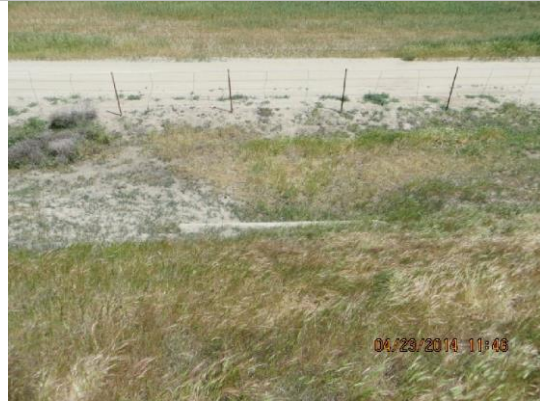
Photo 3 of 3 : UCIP_FA_2015_3843.jpg

Headwall and pipe visible on LS toe.

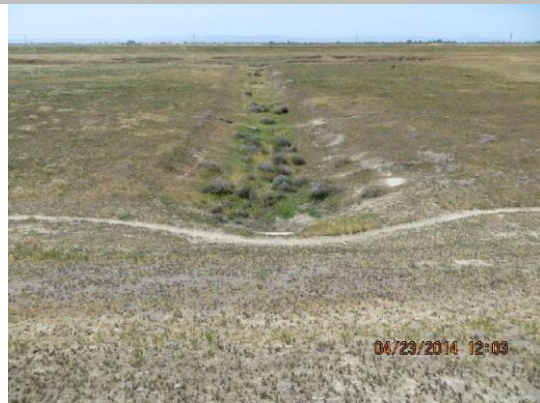
Photo 1 of 3 : UCIP_FA_2015_3844.jpg

LM Start	21.13	Rating **	M	Issue No.	1346
LM End	21.13	Issue Type +	En	Location *	LS
Category	Supplemental			GPS Latitude/Longitude	
				Start	End
Item	DWR UCIP Field Study			37.095603 °	37.095603 °
				-120.541593 °	-120.541593 °
DWR ID					
Action/Comments					
Inspector Comments: FS_ID:39606					
DS_ID:19785					
EP_NO: N/A					
FS_HLM: 21.075					
Repair Type: Non-Urgent					
Crossing Status: Found					
UCIP Comments: Dense vegetation limits the inspector's visibility to identify signs of pipe failure (leaks) along the landward slope.					
Recommend removing vegetation along pipe alignment to conduct proper inspection of structure.					
FIELD_STRUCT_DESC: 24-inch C.M. stormdrain pipe through the levee, 11.8-feet below the crown. Flap gate on the waterward end.					
Concrete headwall on the landward end. Concrete "U" headwall on the waterward end. (USACE-1967). This entry matches the Drainage or Irrigation Structure referenced in O&M manual (HLM 21.08).

Headwall, pipe, and flapgate visible on WS toe.

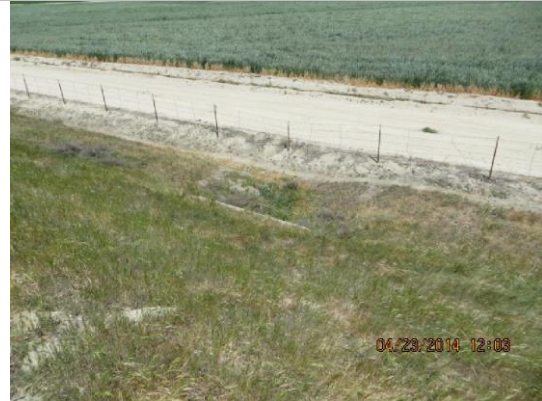
Photo 2 of 3 : UCIP_FA_2015_3845.jpg

Headwall and pipe visible on LS toe.

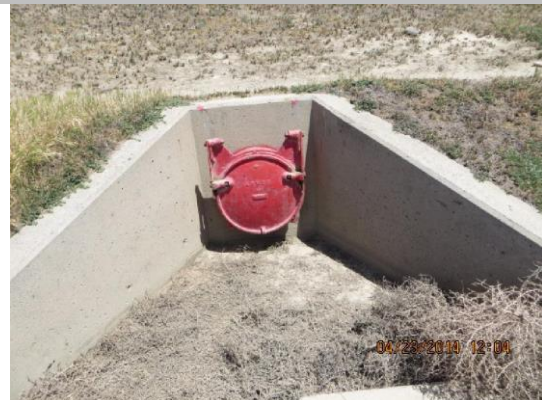
Photo 3 of 3 : UCIP_FA_2015_3846.jpg

Headwall, pipe, and flapgate visible on WS toe.

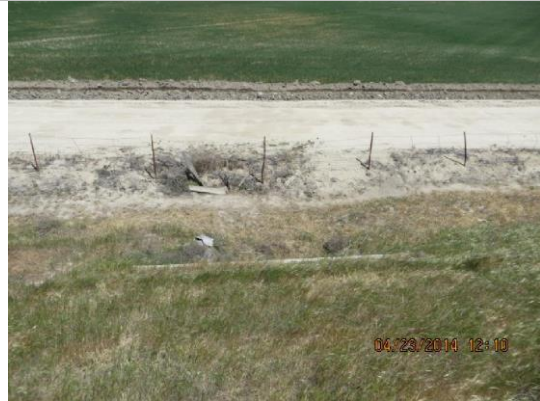
Photo 1 of 3 : UCIP_FA_2015_3938.jpg

LM Start	21.48	Rating **	M	Issue No.	1347
LM End	21.48	Issue Type +	En	Location *	LS
Category	Supplemental			GPS Latitude/Longitude	
				Start	End
Item	DWR UCIP Field Study			37.091755 °	37.091755 °
				-120.537414 °	-120.537414 °
DWR ID					
Action/Comments					
Inspector Comments: FS_ID:39614					
DS_ID:19786					
EP_NO: N/A					
FS_HLM: 21.427					
Repair Type: Non-Urgent					
Crossing Status: Found

Headwall and pipe visible on LS toe.

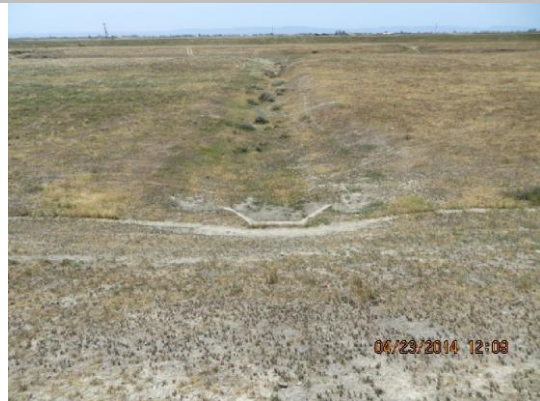
Photo 2 of 3 : UCIP_FA_2015_3939.jpg

Headwall, pipe, and flapgate visible on WS toe.

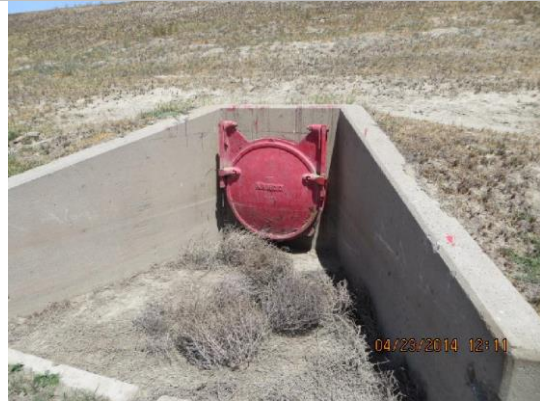
Photo 3 of 3 : UCIP_FA_2015_3940.jpg

Headwall, pipe, and flapgate visible on WS toe.

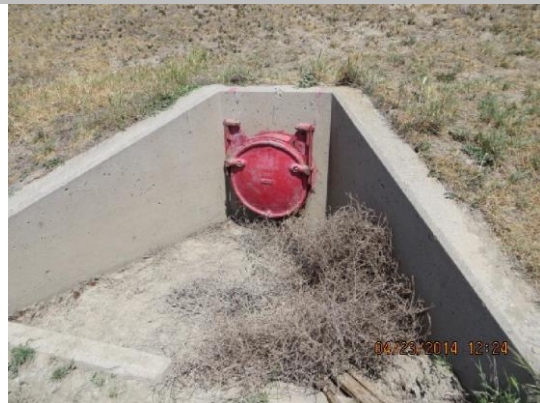
Photo 1 of 3 : UCIP_FA_2015_3941.jpg

LM Start	21.91	Rating **	M	Issue No.	1348
LM End	21.91	Issue Type +	En	Location *	LS
Category	Supplemental			GPS Latitude/Longitude	
				Start	End
Item	DWR UCIP Field Study			37.087525 °	37.087525 °
				-120.532827 °	-120.532827 °
DWR ID					
Action/Comments					
Inspector Comments: FS_ID:39883 DS_ID:19787 EP_NO: N/A FS_HLM: 21.813 Repair Type: Non-Urgent Crossing Status: Found UCIP Comments: Dense vegetation limits the inspector's visibility to identify signs of pipe failure (leaks) along the landward slope. Recommend removing vegetation along pipe alignment to conduct proper inspection of structure. FIELD_STRUCT_DESC: 24-inch C.M. stormdrain pipe through the levee, 12.4-feet below the crown. Flap gate on the waterward end. Concrete headwall on the landward end. Concrete "U" headwall on the waterward end. (USACE-1967). This entry matches the Drainage or Irrigation Structure referenced in O&M manual (HLM 21.81). FS Date: 04/23/2014

Headwall, pipe, and flapgate visible on WS toe.

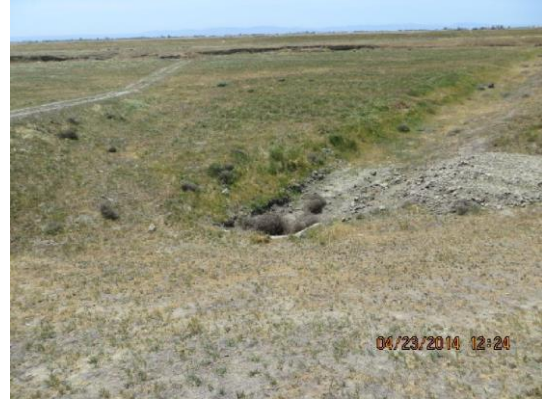
Photo 2 of 3 : UCIP_FA_2015_3942.jpg

Headwall, pipe, and flapgate visible on WS toe.

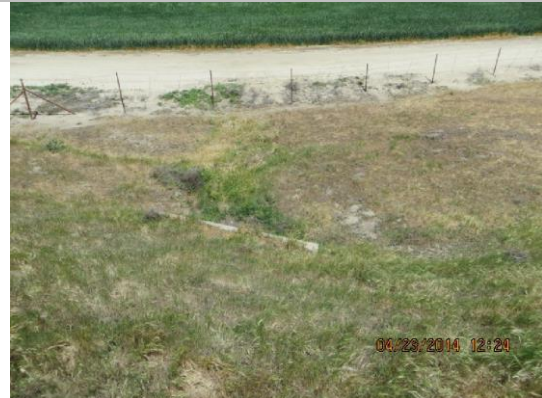
Photo 3 of 3 : UCIP_FA_2015_3943.jpg

Headwall and pipe visible on LS toe.

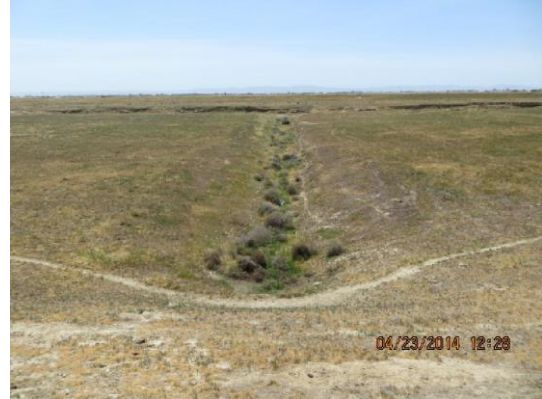
Photo 1 of 3 : UCIP_FA_2015_3944.jpg

LM Start	21.95	Rating **	M	Issue No.	1349
LM End	21.95	Issue Type +	En	Location *	LS
Category	Supplemental			GPS Latitude/Longitude	
				Start	End
Item	DWR UCIP Field Study			37.087108 °	37.087108 °
				-120.532374 °	-120.532374 °
DWR ID					
Action/Comments					
Inspector Comments: FS_ID:39610 DS_ID:19788 EP_NO: N/A FS_HLM: 21.851 Repair Type: Non-Urgent Crossing Status: Found

Headwall, pipe, and flapgate visible on WS toe.

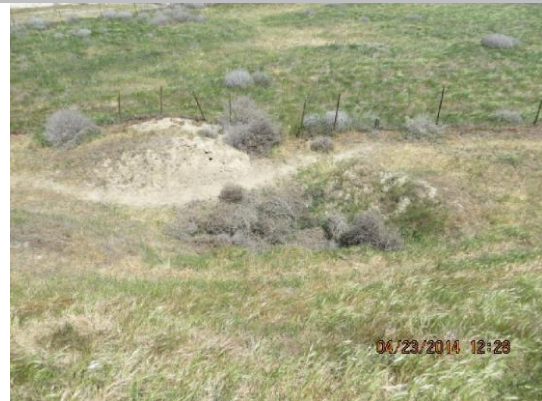
Photo 2 of 3 : UCIP_FA_2015_3945.jpg

Headwall and pipe visible on LS toe.

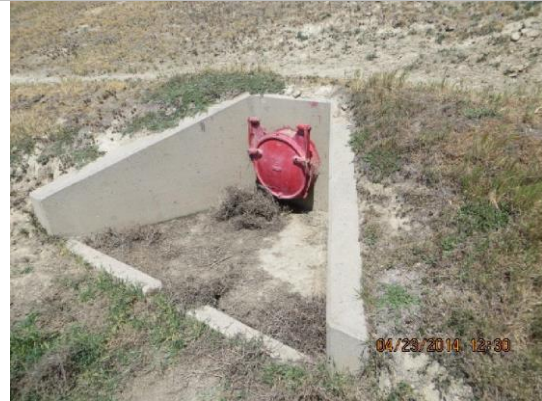
Photo 3 of 3 : UCIP_FA_2015_3946.jpg

Headwall, pipe, and flapgate visible on WS toe.

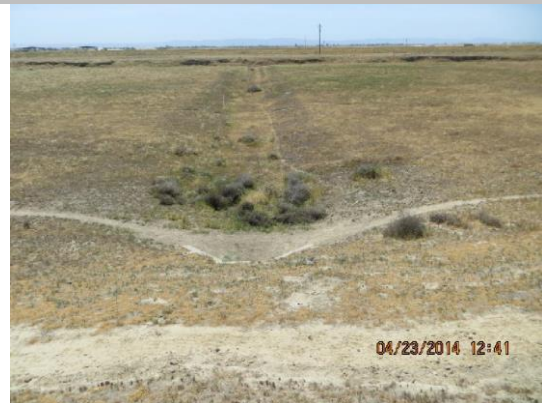
Photo 1 of 3 : UCIP_FA_2015_3972.jpg

LM Start	22.28	Rating **	M	Issue No.	1350
LM End	22.28	Issue Type +	En	Location *	LS
Category	Supplemental			GPS Latitude/Longitude	
				Start	End
Item	DWR UCIP Field Study			37.083410 °	37.083410 °
				-120.528356 °	-120.528356 °
DWR ID					
Action/Comments					
Inspector Comments: FS_ID:39611 DS_ID:19789 EP_NO: N/A FS_HLM: 22.189 Repair Type: Non-Urgent Crossing Status: Found UCIP Comments: Dense vegetation limits the inspector's visibility to identify signs of pipe failure (leaks) along the landward slope. Recommend removing vegetation along pipe alignment to conduct proper inspection of structure. Sediment buildup in pipe visible from landward side--recommend contacting owner to clear pipe. FIELD_STRUCT_DESC: 24-inch C.M. stormdrain pipe through the levee, 10.2-feet below the crown. Flap gate on the waterward end. Concrete headwall on the landward end. Concrete "U" headwall on the waterward end. (USACE-1967). This entry matches the Drainage or Irrigation Structure referenced in O&M manual (HLM 22.19). FS Date: 04/23/2014

Headwall, pipe, and flapgate visible on WS toe.

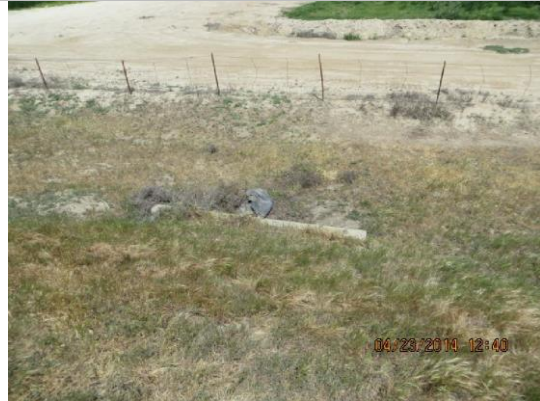
Photo 2 of 3 : UCIP_FA_2015_3973.jpg

Item	DWR UCIP Field Study			37.083410 °	37.083410 °	
				-120.528356 °	-120.528356 °	
DWR ID						
Action/Comments						
Inspector Comments: FS_ID:39611 DS_ID:19789 EP_NO: N/A FS_HLM: 22.189 Repair Type: Non-Urgent Crossing Status: Found UCIP Comments: Dense vegetation limits the inspector's visibility to identify signs of pipe failure (leaks) along the landward slope. Recommend removing vegetation along pipe alignment to conduct proper inspection of structure. Sediment buildup in pipe visible from landward side--recommend contacting owner to clear pipe. FIELD_STRUCT_DESC: 24-inch C.M. stormdrain pipe through the levee, 10.2-feet below the crown. Flap gate on the waterward end. Concrete headwall on the landward end. Concrete "U" headwall on the waterward end. (USACE-1967). This entry matches the Drainage or Irrigation Structure referenced in O&M manual (HLM 22.19). FS Date: 04/23/2014

Headwall and pipe visible on LS toe.

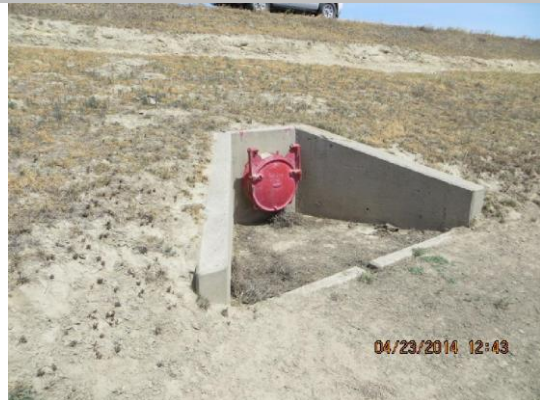
Photo 3 of 3 : UCIP_FA_2015_3974.jpg

Headwall, pipe, and flapgate visible on WS toe.

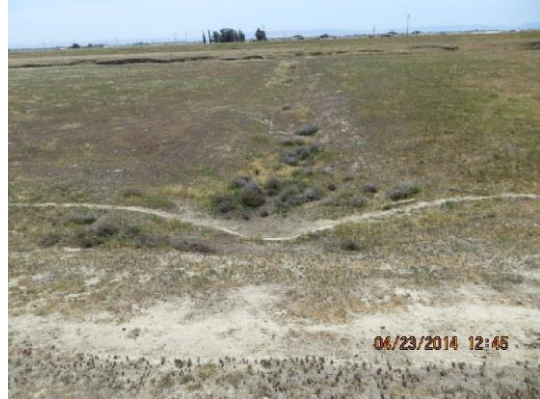
Photo 1 of 3 : UCIP_FA_2015_3975.jpg

LM Start	22.55	Rating **	M	Issue No.	1351
LM End	22.55	Issue Type +	En	Location *	LS
Category	Supplemental			GPS Latitude/Longitude	
				Start	End
Item	DWR UCIP Field Study			37.080486 °	37.080486 °
				-120.525180 °	-120.525180 °
DWR ID					
Action/Comments					
Inspector Comments: FS_ID:39613 DS_ID:19790 EP_NO: N/A FS_HLM: 22.457 Repair Type: Non-Urgent Crossing Status: Found

Headwall, pipe, and flapgate visible on WS toe.

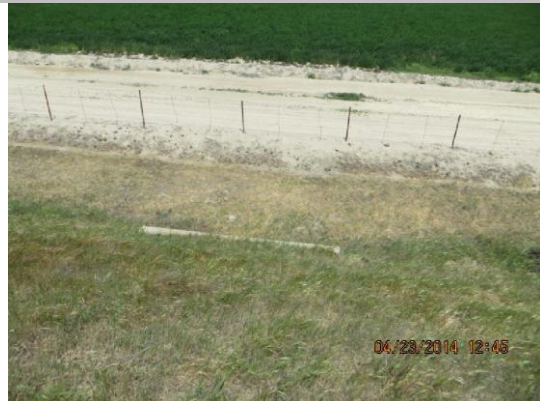
Photo 2 of 3 : UCIP_FA_2015_3976.jpg

Headwall and pipe visible on LS toe.

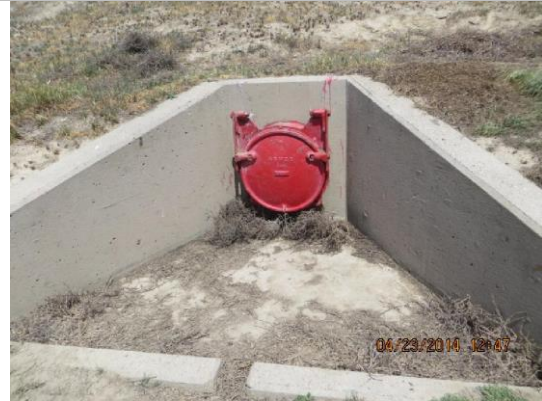
Photo 3 of 3 : UCIP_FA_2015_3977.jpg

Headwall, pipe, and flapgate visible on WS toe.

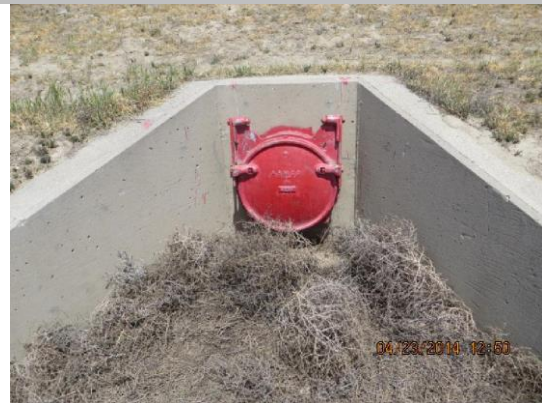
Photo 1 of 3 : UCIP_FA_2015_3978.jpg

LM Start	22.89	Rating **	M	Issue No.	1352
LM End	22.89	Issue Type +	En	Location *	LS
Category	Supplemental			GPS Latitude/Longitude	
				Start	End
Item	DWR UCIP Field Study			37.076830 °	37.076830 °
				-120.521116 °	-120.521116 °
DWR ID					
Action/Comments					
Inspector Comments: FS_ID:39616					
DS_ID:19791					
EP_NO: N/A					
FS_HLM: 22.794					
Repair Type: Non-Urgent					
Crossing Status: Found					
UCIP Comments: Dense vegetation limits the inspector's visibility to identify signs of pipe failure (leaks) along the landward slope.					
Recommend removing vegetation along pipe alignment to conduct proper inspection of structure. Sediment buildup in pipe visible from landward side--recommend contacting owner to clear pipe.					
FIELD_STRUCT_DESC: 24-inch C.M. stormdrain pipe through the levee, 12.2-feet below the crown. Flap gate on the waterward end. Concrete headwall on the landward end. Concrete "U" headwall on the waterward end. (USACE-1967). This entry matches the Drainage or Irrigation Structure referenced in O&M manual (HLM 22.94).

Headwall, pipe, and flapgate visible on WS toe.

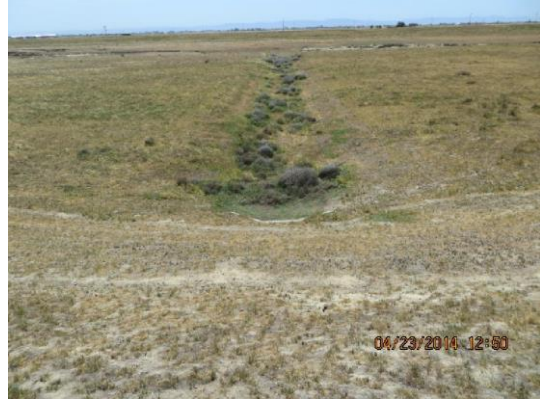
Photo 2 of 3 : UCIP_FA_2015_3979.jpg

Headwall, pipe, and flapgate visible on WS toe.

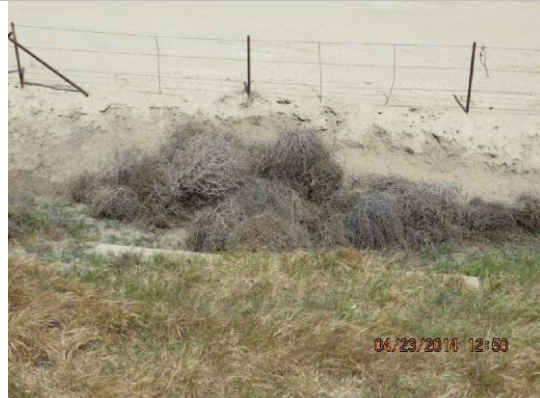
Photo 3 of 3 : UCIP_FA_2015_3980.jpg

Headwall and pipe visible on LS toe.

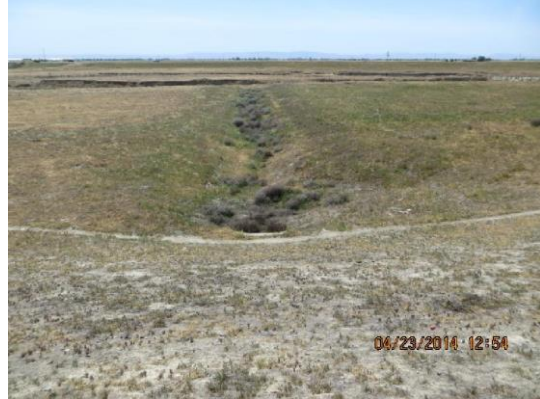
Photo 1 of 3 : UCIP_FA_2015_3981.jpg

LM Start	23.03	Rating **	M	Issue No.	1353
LM End	23.03	Issue Type +	En	Location *	LS
Category	Supplemental			GPS Latitude/Longitude	
				Start	End
Item	DWR UCIP Field Study			37.075387 °	37.075387 °
				-120.519406 °	-120.519406 °
DWR ID					
Action/Comments					
Inspector Comments: FS_ID:39617					
DS_ID:19792					
EP_NO: N/A					
FS_HLM: 22.931					
Repair Type: Non-Urgent					
Crossing Status: Found

Headwall, pipe, and flapgate visible on WS toe.

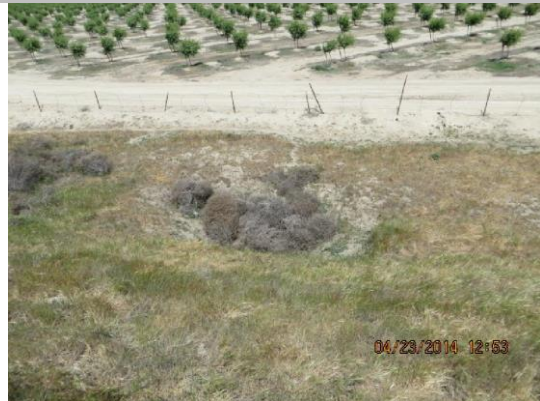
Photo 2 of 3 : UCIP_FA_2015_3982.jpg

Headwall and pipe visible on LS toe.

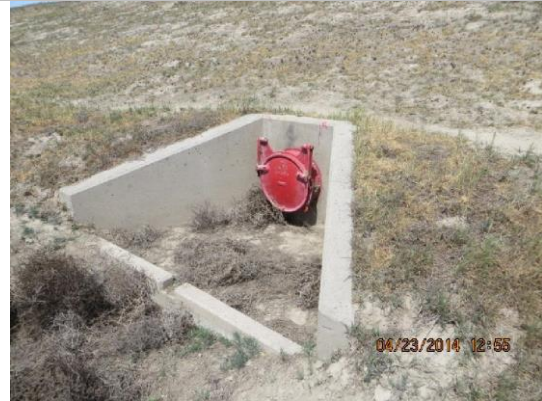
Photo 3 of 3 : UCIP_FA_2015_3983.jpg

Headwall, pipe, and flapgate visible on WS toe.

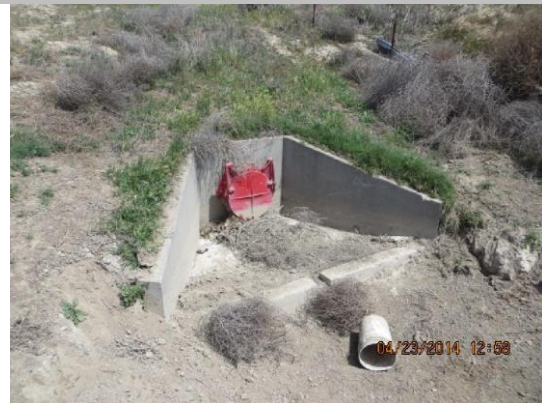
Photo 1 of 3 : UCIP_FA_2015_3984.jpg

LM Start	23.17	Rating **	M	Issue No.	1354
LM End	23.17	Issue Type +	En	Location *	LS
Category	Supplemental			GPS Latitude/Longitude	
				Start	End
Item	DWR UCIP Field Study			37.073901 °	37.073901 °
				-120.517651 °	-120.517651 °
DWR ID					
Action/Comments					
Inspector Comments: FS_ID:39618 DS_ID:19793 EP_NO: N/A FS_HLM: 23.072 Repair Type: Non-Urgent Crossing Status: Found UCIP Comments: Debris blocking closure of outlet. Dense vegetation limits the inspector's visibility to identify signs of pipe failure (leaks) along the waterward and landward slopes. Recommend removing vegetation along pipe alignment to conduct proper inspection of structure. FIELD_STRUCT_DESC: 24-inch C.M. stormdrain pipe through the levee, 11.5-feet below the crown. Flap gate on the waterward end. Concrete headwall on the landward end. Concrete "U" headwall on the waterward end. FS Date: 04/23/2014

Headwall, pipe, and flapgate visible on WS toe.

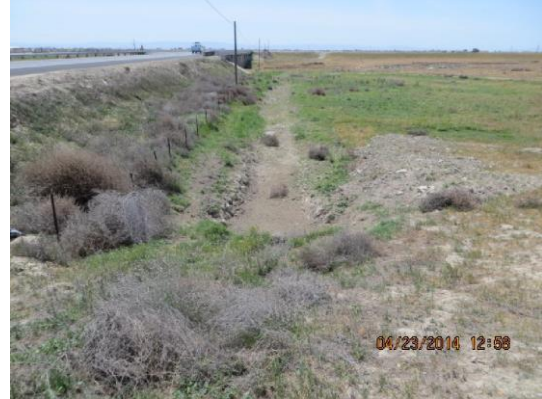
Photo 2 of 3 : UCIP_FA_2015_3985.jpg

Headwall, pipe, and flapgate visible on WS toe.

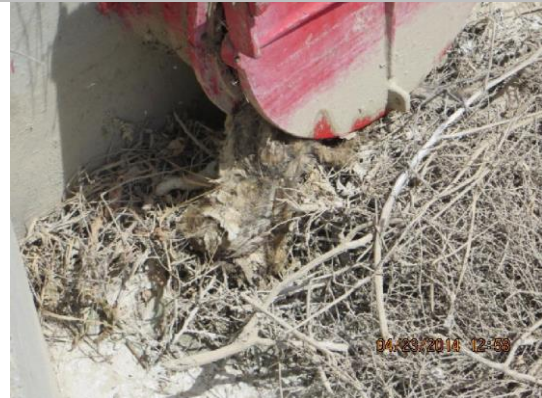
Photo 3 of 3 : UCIP_FA_2015_4099.jpg

Item	DWR UCIP Field Study			37.073901 °	37.073901 °	
				-120.517651 °	-120.517651 °	
DWR ID						
Action/Comments						
Inspector Comments: FS_ID:39618 DS_ID:19793 EP_NO: N/A FS_HLM: 23.072 Repair Type: Non-Urgent Crossing Status: Found UCIP Comments: Debris blocking closure of outlet. Dense vegetation limits the inspector's visibility to identify signs of pipe failure (leaks) along the waterward and landward slopes. Recommend removing vegetation along pipe alignment to conduct proper inspection of structure. FIELD_STRUCT_DESC: 24-inch C.M. stormdrain pipe through the levee, 11.5-feet below the crown. Flap gate on the waterward end. Concrete headwall on the landward end. Concrete "U" headwall on the waterward end. FS Date: 04/23/2014

Debris blocking closure of outlet on WS toe.

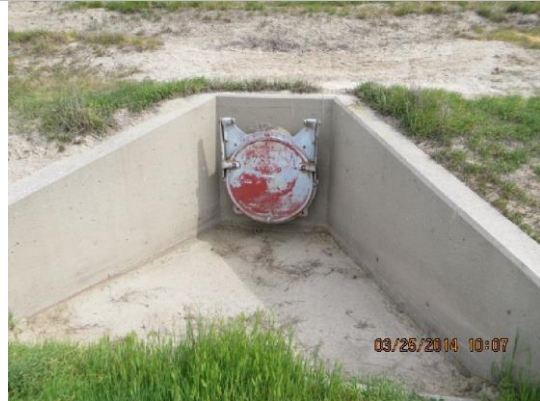
Photo 1 of 3 : UCIP_FA_2015_4043.jpg

LM Start	23.72	Rating **	M	Issue No.	1355
LM End	23.72	Issue Type +	En	Location *	LS
Category	Supplemental			GPS Latitude/Longitude	
				Start	End
Item	DWR UCIP Field Study			37.067799 °	37.067799 °
				-120.511093 °	-120.511093 °
DWR ID					
Action/Comments					
Inspector Comments: FS_ID:39621					
DS_ID:19796					
EP_NO: N/A					
FS_HLM: 23.626					
Repair Type: Non-Urgent					
Crossing Status: Found

Flapgate on Concrete headwall on WS toe.

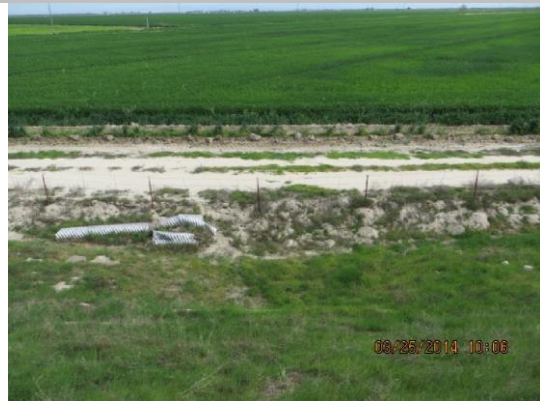
Photo 2 of 3 : UCIP_FA_2015_4044.jpg

Concrete headwall on LS toe.

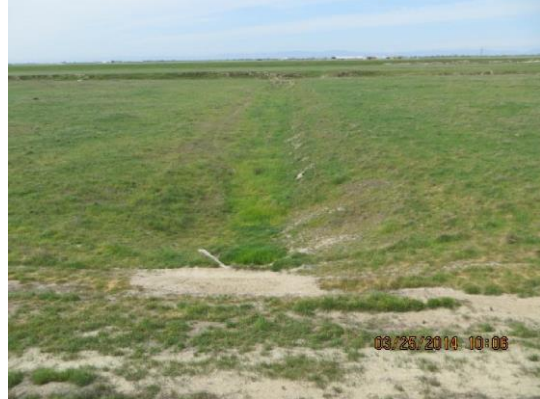
Photo 3 of 3 : UCIP_FA_2015_4045.jpg

Concrete headwall on WS toe.

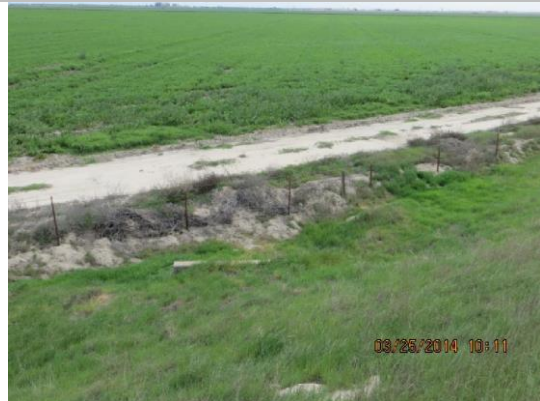
Photo 1 of 3 : UCIP_FA_2015_4189.jpg

Concrete headwall on LS toe.

Action/Comments					
Inspector Comments: FS_ID:39620 DS_ID:19797 EP_NO: N/A FS_HLM: 23.927 Repair Type: Non-Urgent Crossing Status: Found UCIP Comments: Minor sediment/debris buildup in pipe visible from landward side--recommend contacting owner to clear pipe. FIELD_STRUCT_DESC: 36-inch C.M. stormdrain pipe through the levee, 12.1 feet below the crown. Flap gate on the waterward end. Concrete headwall on the landward end. Concrete "U" headwall on the waterward end. (USACE-1967). This entry matches the Drainage or Irrigation Structure referenced in O&M manual (HLM 23.85). FS Date: 03/25/2014

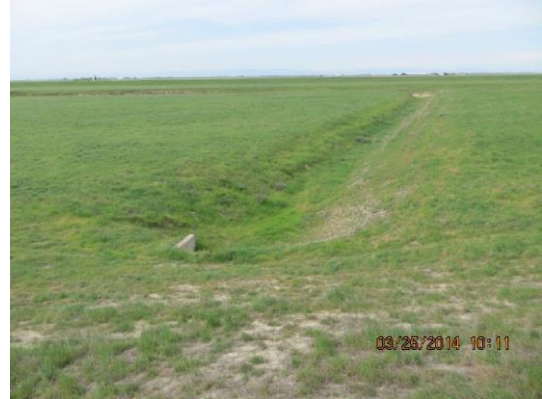
Photo 2 of 3 : UCIP_FA_2015_4190.jpg

Concrete headwall on WS toe.

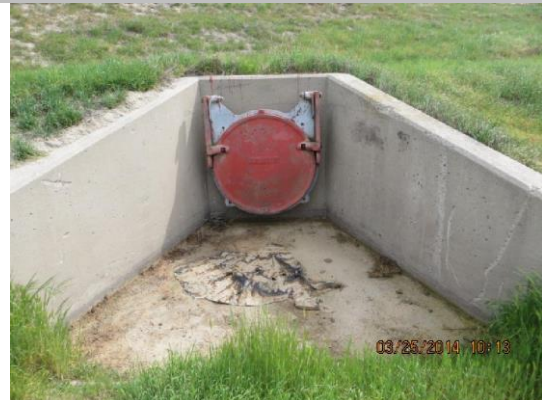
Photo 3 of 3 : UCIP_FA_2015_4276.jpg

Flapgate at Concrete headwall on WS toe.

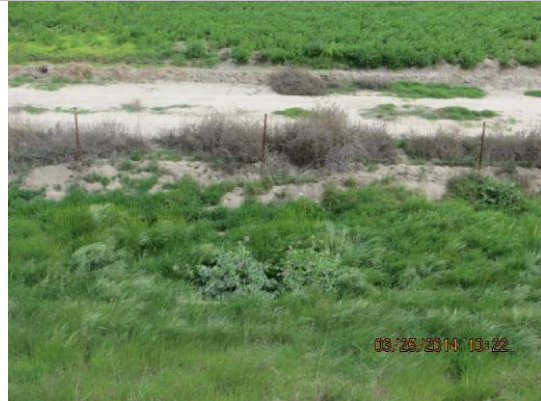
Photo 1 of 3 : UCIP_FA_2015_1246.jpg

Concrete headwall at LS toe.

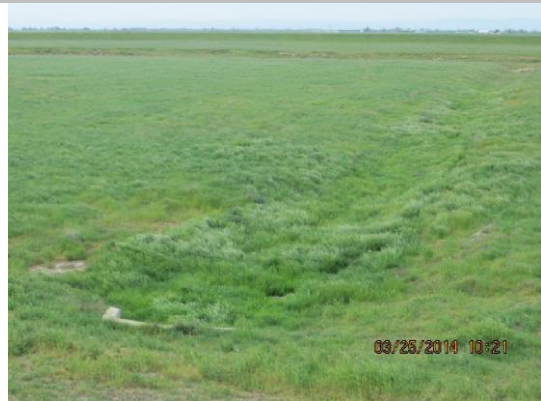
Photo 2 of 3 : UCIP_FA_2015_1247.jpg

Concrete headwall at WS toe.

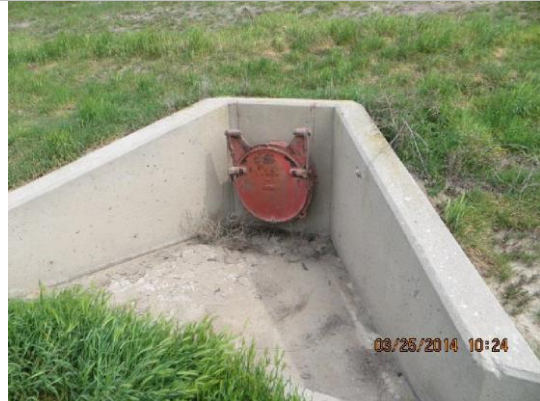
Photo 3 of 3 : UCIP_FA_2015_4191.jpg

Flapgate at concrete headwall at WS toe.

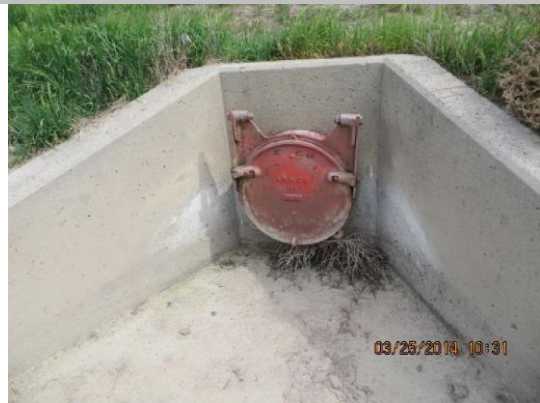
Photo 1 of 3 : UCIP_FA_2015_1248.jpg

Flapgate at Concrete headwall on WS toe.

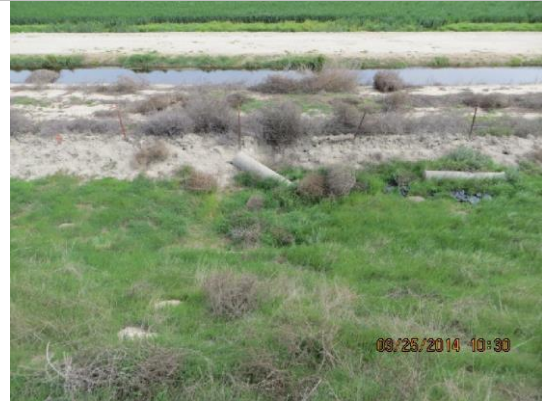
Photo 2 of 3 : UCIP_FA_2015_1249.jpg

Concrete headwall on LS toe.

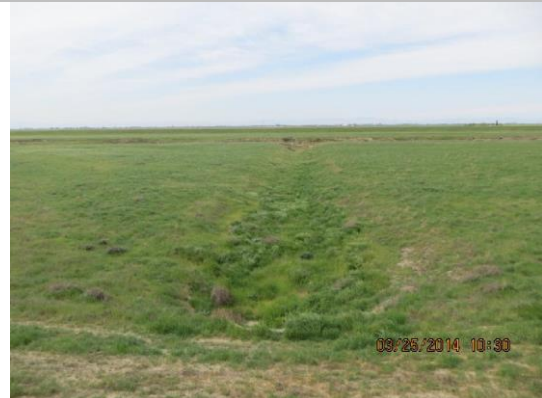
Photo 3 of 3 : UCIP_FA_2015_1250.jpg

Concrete headwall on WS toe.

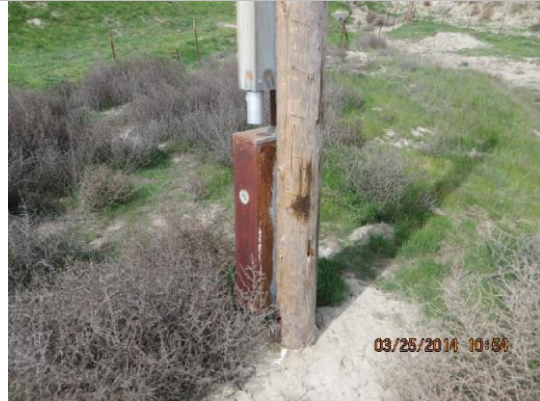
Photo 1 of 3 : UCIP_FA_2015_1251.jpg

Power pole, meter, and electrical panel off LS toe.

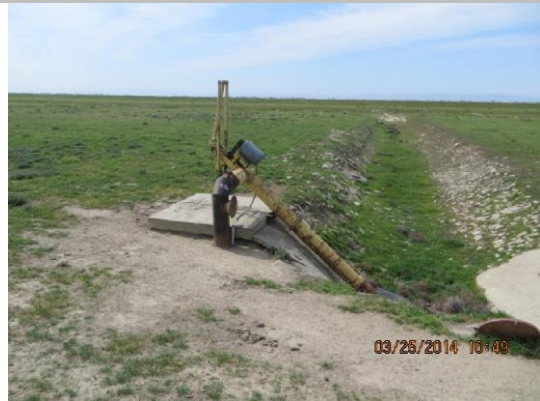
Photo 2 of 3 : UCIP_FA_2015_1252.jpg

Slant pump at channel on WS toe.

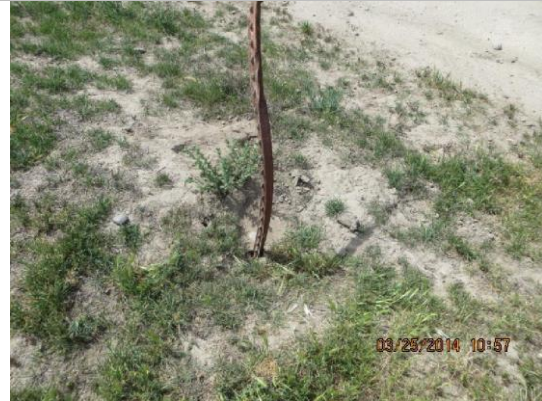
Photo 3 of 3 : UCIP_FA_2015_1253.jpg

Buried Siphon breaker on WS shoulder.

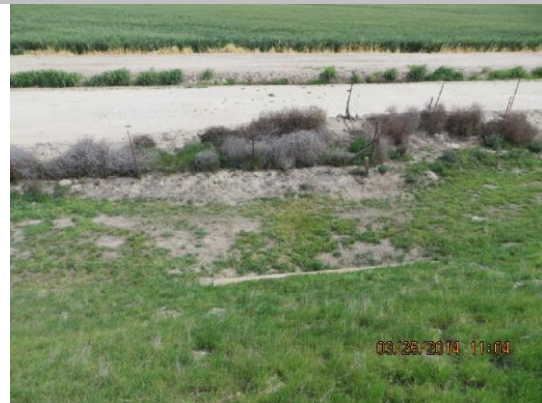
Photo 1 of 3 : UCIP_FA_2015_1254.jpg

Concrete headwall on LS toe.

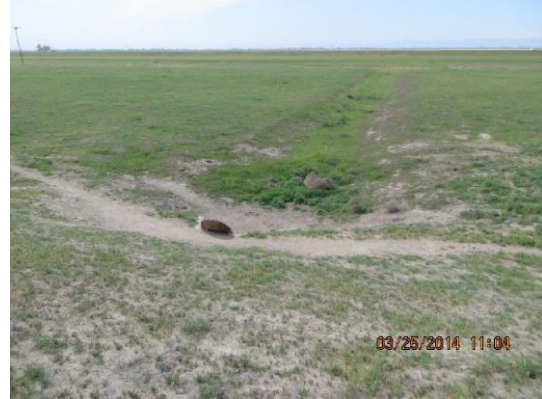
Photo 2 of 3 : UCIP_FA_2015_1255.jpg

Inspector Comments: FS_ID:32789
 DS_ID:19803
 EP_NO: N/A
 FS_HLM: 25.145
 Repair Type: Non-Urgent
 Crossing Status: Found
 UCIP Comments: Flapgate propped open during flood season.
 FIELD_STRUCT_DESC: 30-inch C.M. stormdrain pipe through the levee, 11.3 feet below the crown. Flap gate on the waterward end. Concrete headwall on the landward end. Concrete "U" headwall on the waterward end. (USACE-1967). This entry matches the Drainage or Irrigation Structure referenced in O&M manual (HLM 25.13).
 FS Date: 03/25/2014

Concrete headwall and flapgate on WS toe.

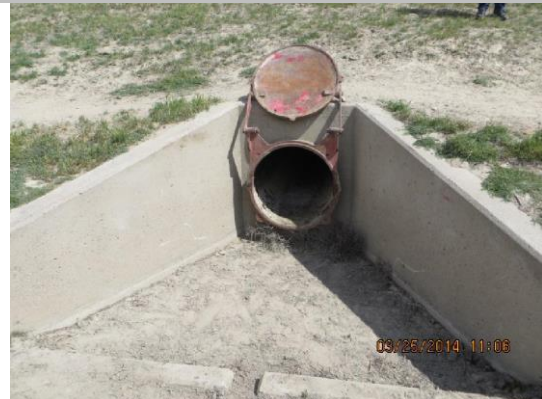
Photo 3 of 3 : UCIP_FA_2015_1256.jpg

Concrete headwall and flapgate on WS toe.

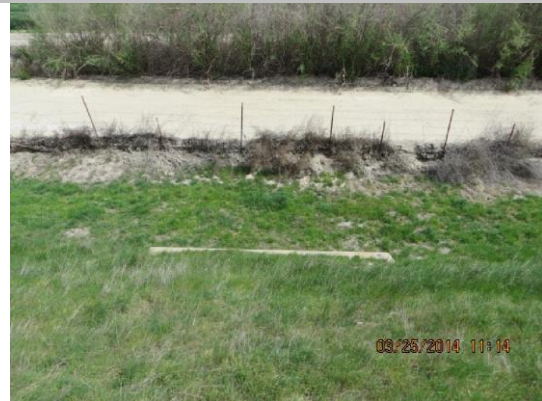
Photo 1 of 3 : UCIP_FA_2015_1257.jpg

Concrete headwall on LS toe.

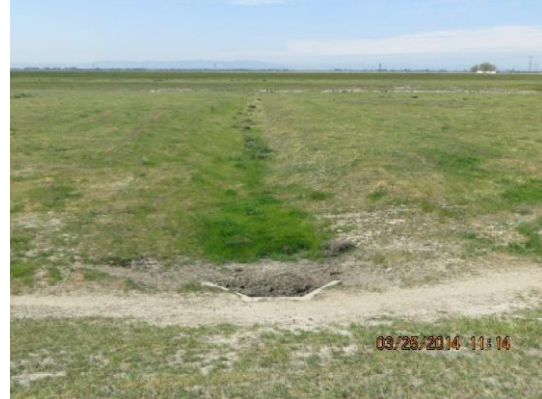
Photo 2 of 3 : UCIP_FA_2015_1258.jpg

Concrete headwall on WS toe.

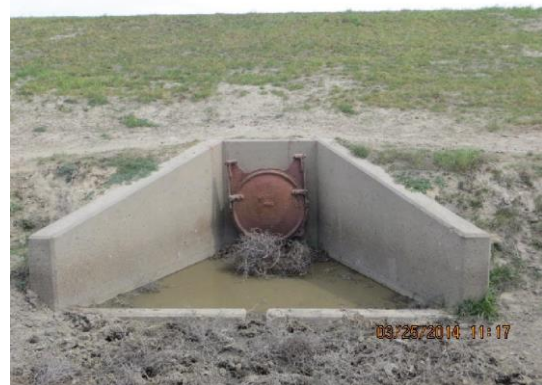
Photo 3 of 3 : UCIP_FA_2015_1259.jpg

Flapgate on concrete headwall at WS toe.

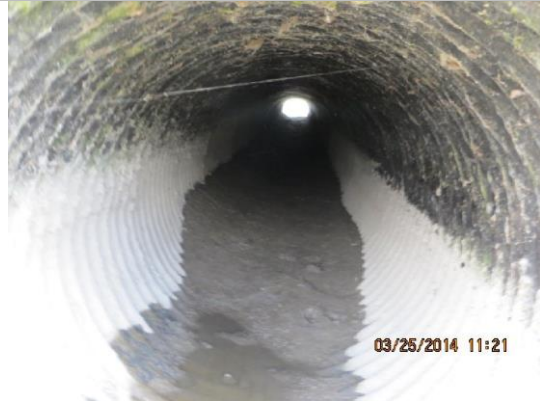
Photo 1 of 3 : UCIP_FA_2015_1260.jpg

Inside pipe on LS toe.

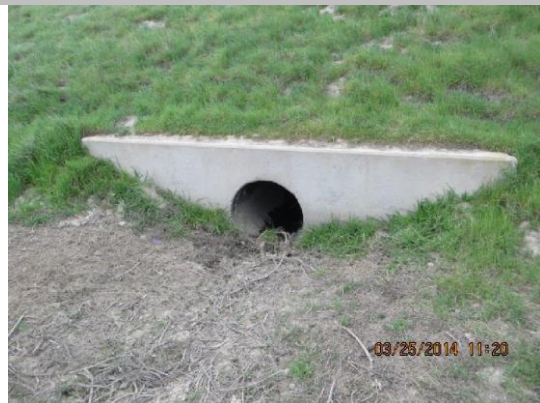
Photo 2 of 3 : UCIP_FA_2015_1261.jpg

Concrete headwall on LS toe.

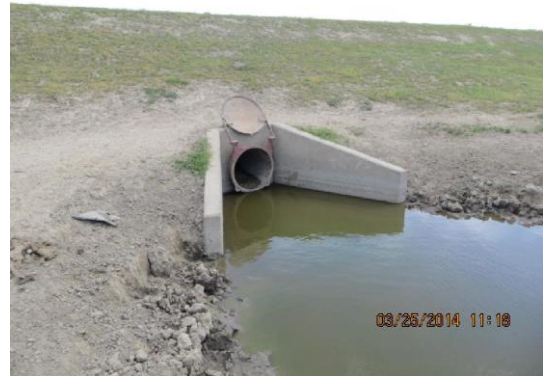
Photo 3 of 3 : UCIP_FA_2015_4208.jpg

Flapgate on headwall at WS toe.

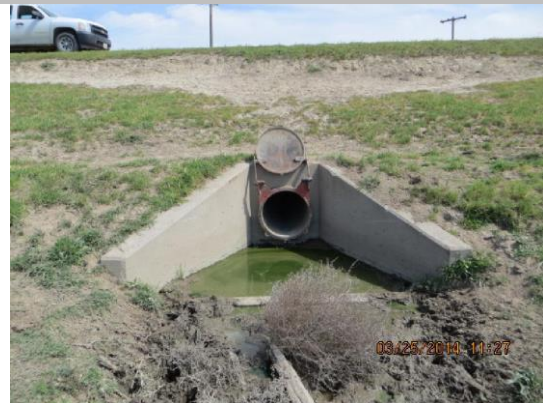
Photo 1 of 3 : UCIP_FA_2015_4209.jpg

Flapgate on Concrete headwall at WS toe.

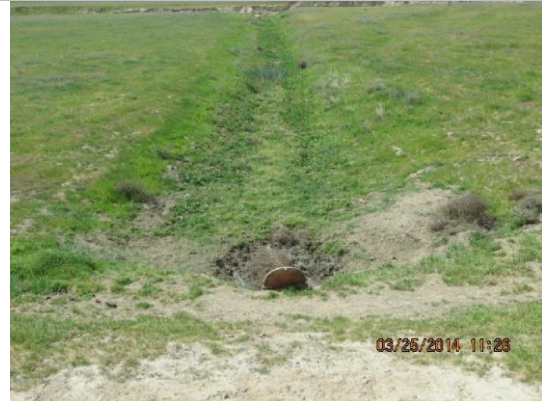
Photo 2 of 3 : UCIP_FA_2015_4210.jpg

Concrete headwall on WS toe.

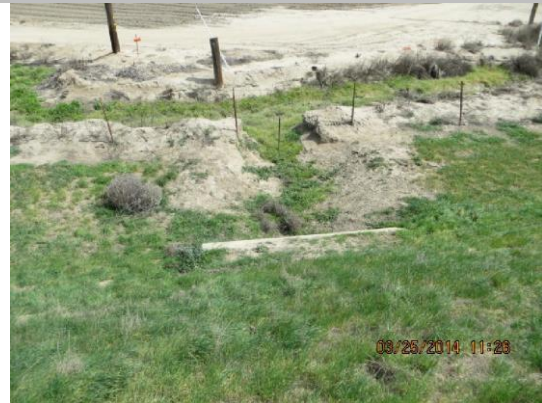
Photo 3 of 3 : UCIP_FA_2015_4211.jpg

Inspector Comments: FS_ID:39627
 DS_ID:19806
 EP_NO: N/A
 FS_HLM: 26.106
 Repair Type: Non-Urgent
 Crossing Status: Found
 UCIP Comments: Sediment buildup in pipe visible from landward side--recommend contacting owner to clear pipe.
 FIELD_STRUCT_DESC: 24-inch C.M. stormdrain pipe through the levee, 10.0 feet below the crown. Flap gate on the waterward end. Concrete headwall on the landward end. Concrete "U" headwall on the waterward end. (USACE-1967). This entry matches the Drainage or Irrigation Structure referenced in O&M manual (HLM 26.11).
 FS Date: 03/25/2014

Concrete headwall on LS toe.

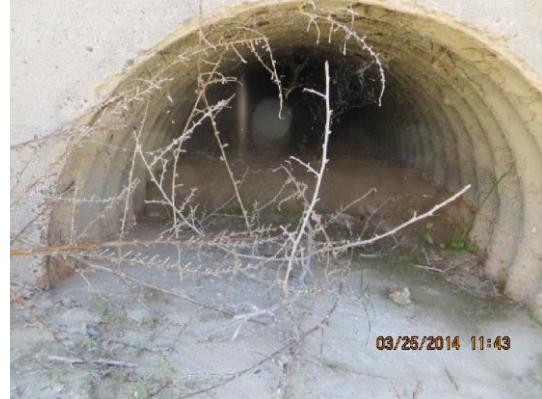
Photo 1 of 3 : UCIP_FA_2015_4277.jpg

Silt buildup in pipe at LS toe.

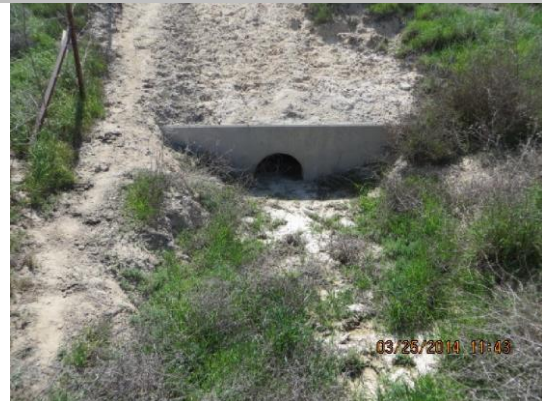
Photo 2 of 3 : UCIP_FA_2015_4278.jpg

Concrete headwall on LS toe.

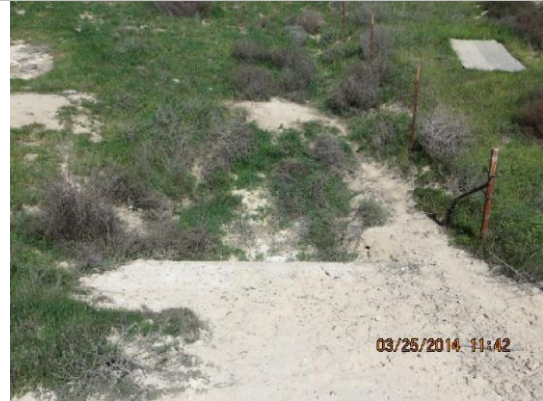
Photo 3 of 3 : UCIP_FA_2015_4279.jpg

Concrete headwall on LS toe.

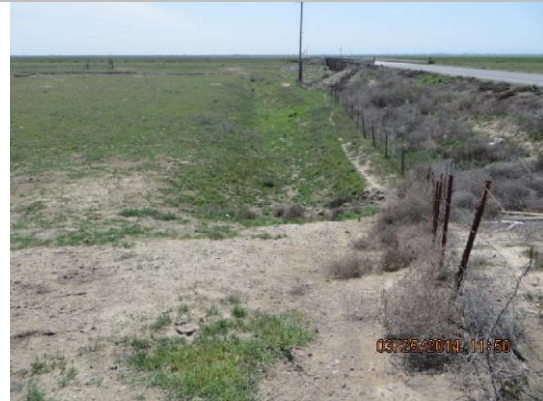
Photo 1 of 3 : UCIP_FA_2015_4283.jpg

LM Start	26.97	Rating **	M	Issue No.	1364
LM End	26.97	Issue Type +	En	Location *	LS
Category	Supplemental			GPS Latitude/Longitude	
				Start	End
Item	DWR UCIP Field Study			37.032680 °	37.032680 °
				-120.473454 °	-120.473454 °
DWR ID					
Action/Comments					
Inspector Comments: FS_ID:32806 DS_ID:19748 EP_NO: N/A FS_HLM: 26.875 Repair Type: Non-Urgent Crossing Status: Found UCIP Comments: Tumble weed buildup at inlet mat create blockage and should be removed. FIELD_STRUCT_DESC: 24-inch C.M. stormdrain pipe through the levee, 11.3 feet below the crown. Flap gate on the waterward end. Concrete headwall on the landward end. Concrete "U" headwall on the waterward end. (USACE-1967). This entry matches the Drainage or Irrigation Structure referenced in O&M manual (HLM 26.87). FS Date: 03/25/2014

Concrete headwall at WS toe.

Inspector Comments: FS_ID:32806
 DS_ID:19748
 EP_NO: N/A
 FS_HLM: 26.875
 Repair Type: Non-Urgent
 Crossing Status: Found
 UCIP Comments: Tumble weed buildup at inlet mat create blockage and should be removed.
 FIELD_STRUCT_DESC: 24-inch C.M. stormdrain pipe through the levee, 11.3 feet below the crown. Flap gate on the waterward end. Concrete headwall on the landward end. Concrete "U" headwall on the waterward end. (USACE-1967). This entry matches the Drainage or Irrigation Structure referenced in O&M manual (HLM 26.87).
 FS Date: 03/25/2014

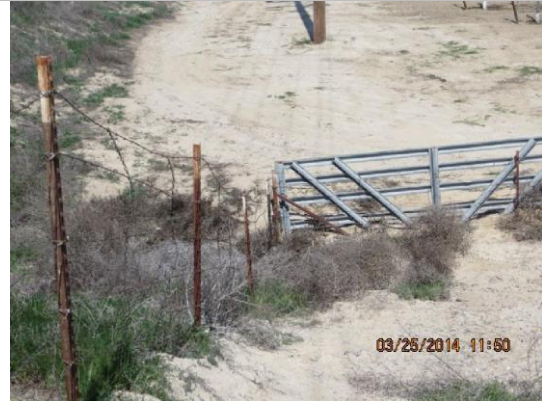
Photo 2 of 3 : UCIP_FA_2015_4284.jpg

Concrete headwall at LS toe.

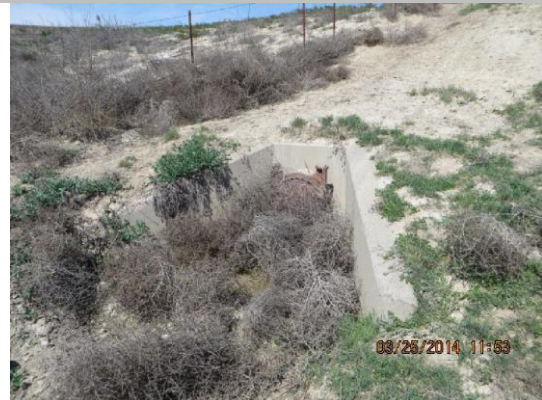
Photo 3 of 3 : UCIP_FA_2015_4285.jpg

Flapgate and Concrete headwall at WS toe.

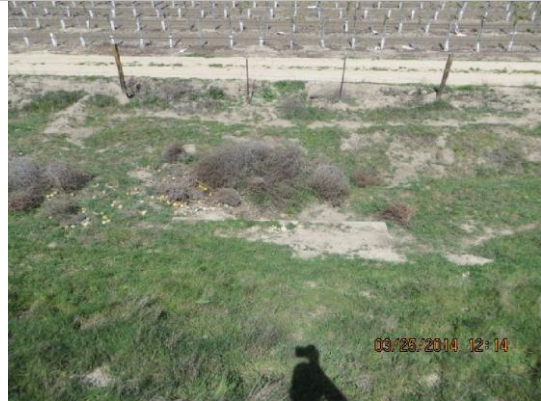
Photo 1 of 3 : UCIP_FA_2015_4286.jpg

Concrete headwall on LS toe.

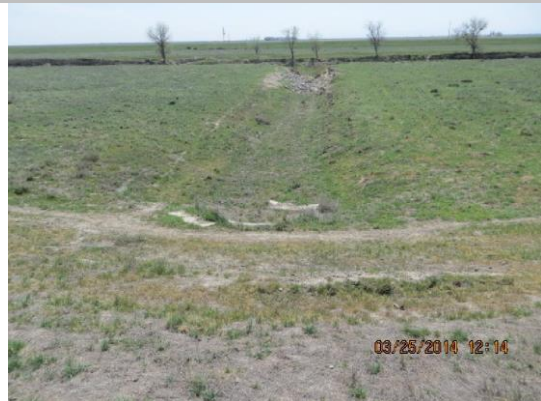
Photo 2 of 3 : UCIP_FA_2015_4287.jpg

Concrete headwall on WS toe.

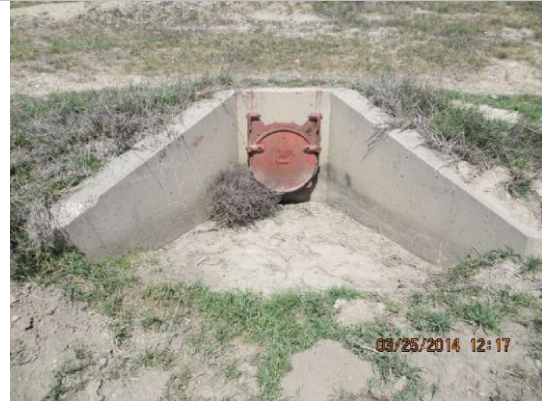
Photo 3 of 3 : UCIP_FA_2015_4288.jpg

Flapgate on Concrete headwall at WS toe.

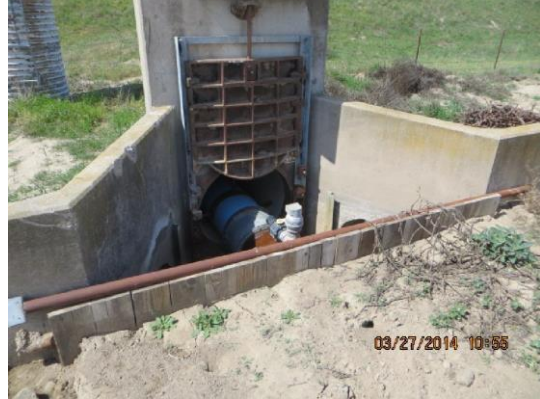
Photo 2 of 3 : UCIP_FA_2015_4455.jpg

24-inch PVC pipe sleeved through 48-inch concrete pipe. Rails on Slide gate rusted beyond use.

24-inch PVC pipe sleeved through 48-inch concrete pipe.

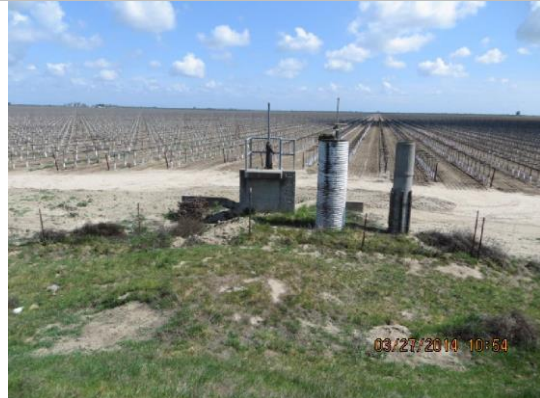
Photo 3 of 3 : UCIP_FA_2015_4477.jpg

Slide gate mounted to concrete headwall on LS toe.

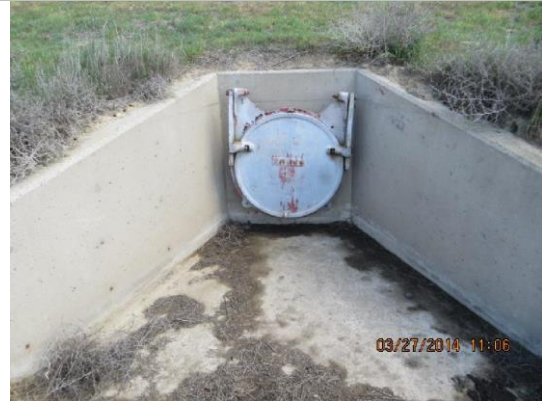
Photo 1 of 3 : UCIP_FA_2015_4478.jpg

Flapgate on Concrete headwall at WS toe.

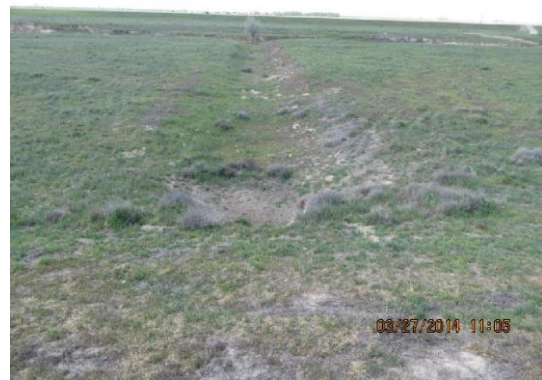
Photo 2 of 3 : UCIP_FA_2015_4479.jpg

Concrete headwall on WS toe.

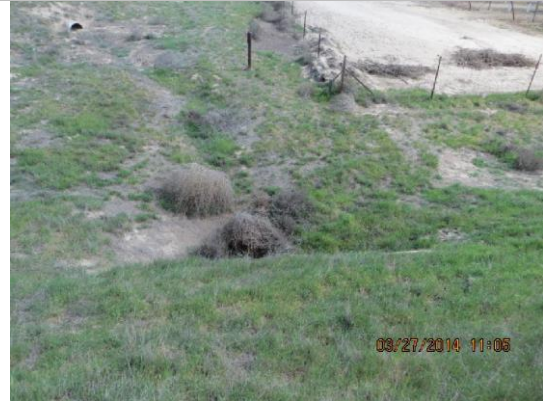
Photo 3 of 3 : UCIP_FA_2015_4480.jpg

Concrete headwall on LS toe.

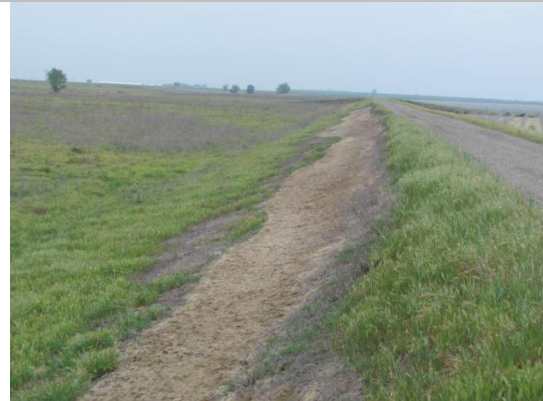
Photo 1 of 2 : FA_2015_NA0010_123_171_20150914_00012.jpg

LM Start	29.68	Rating **	M	Issue No.	171
LM End	29.80	Issue Type +	Ma	Location *	LS
Category	Earthen Levee			GPS Latitude/Longitude	
				Start	End
Item	Erosion / Bank Caving			37.020272 °	37.018712 °
				-120.433737 °	-120.432682 °
DWR ID	DWR_NA0010_05_s_2014_171				
Action/Comments					
Note and monitor erosion site.					
Inspector Comments: Waterside erosion caused by livestock.

Looking south at erosion caused by livestock on landside slope.

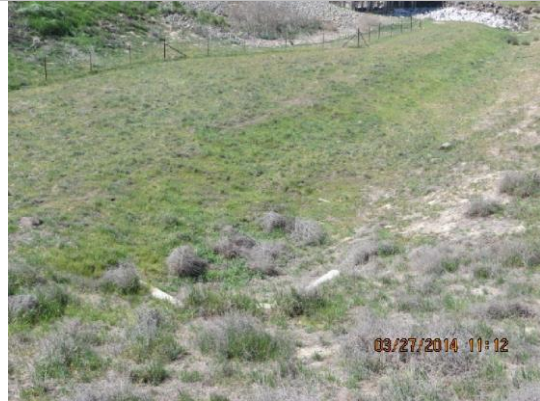
Photo 1 of 3 : UCIP_FA_2015_4481.jpg

Concrete headwall on WS toe.

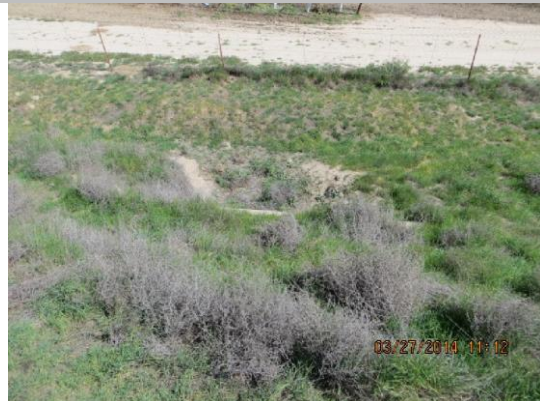
Photo 2 of 3 : UCIP_FA_2015_4482.jpg

Concrete headwall on LS toe.

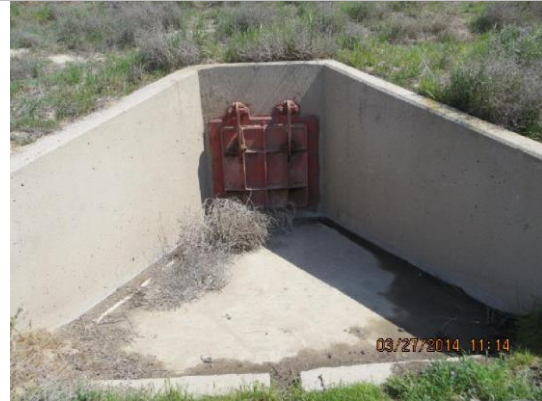
Photo 3 of 3 : UCIP_FA_2015_4483.jpg

Flapgate on Concrete headwall at WS toe.

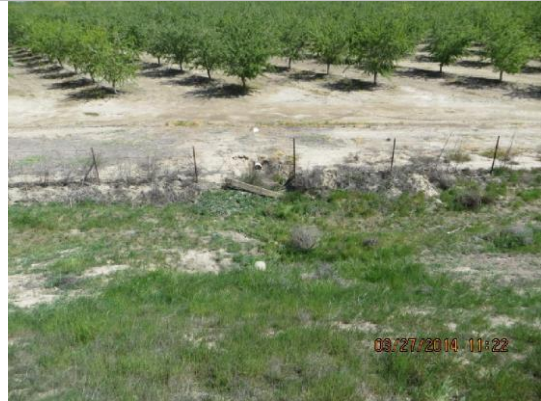
Photo 1 of 3 : UCIP_FA_2015_4484.jpg

Concrete headwall on LS toe.

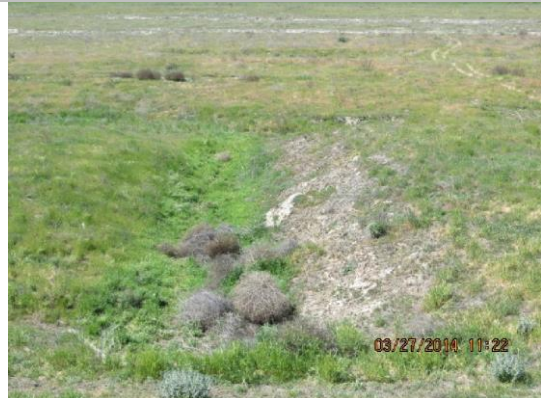
Photo 2 of 3 : UCIP_FA_2015_4485.jpg

Concrete headwall on WS toe.

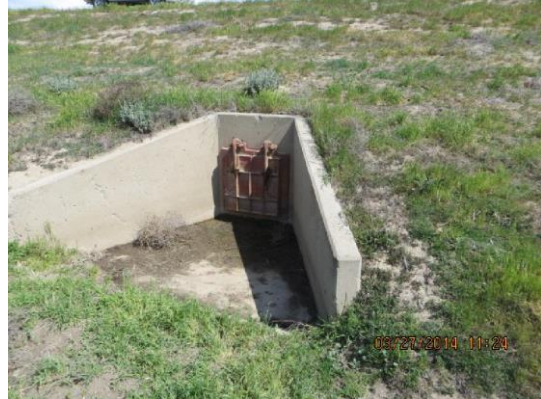
Photo 3 of 3 : UCIP_FA_2015_4486.jpg

Flapgate on Concrete headwall at WS toe.

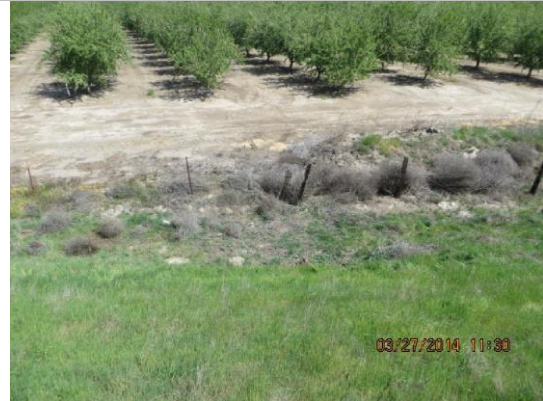
Photo 1 of 3 : UCIP_FA_2015_4487.jpg

Concrete headwall on LS toe.

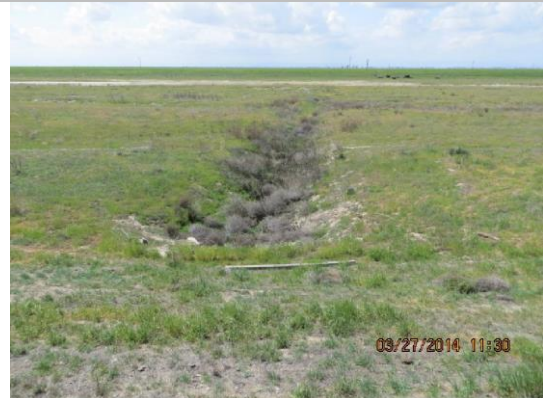
Photo 2 of 3 : UCIP_FA_2015_4488.jpg

Concrete headwall on WS toe.
