**Flood Control Project Maintenance
Levee Inspections**

Fall 2015 Levee Maintenance Deficiency Summary Report

San Joaquin River Basin

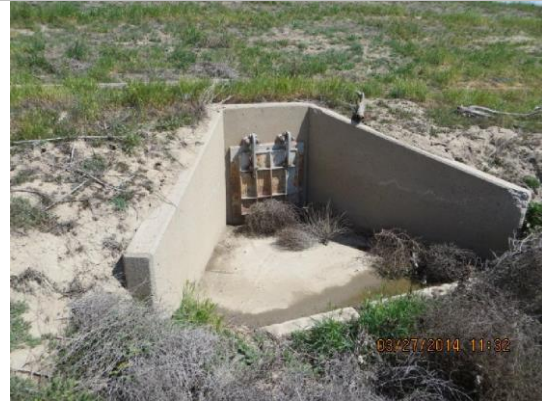
Photo 3 of 3 : UCIP_FA_2015_4489.jpg

Flapgate on Concrete headwall at WS toe.

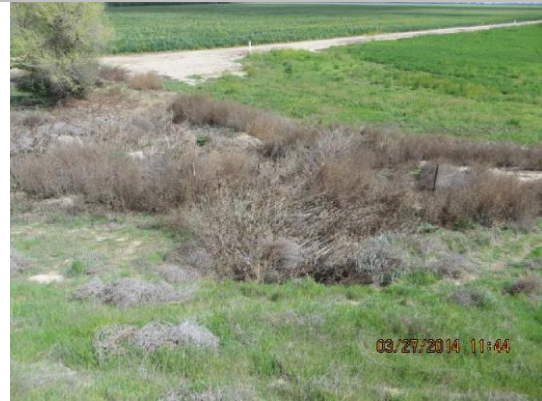
Photo 1 of 3 : UCIP_FA_2015_4490.jpg

Concrete headwall on LS toe.

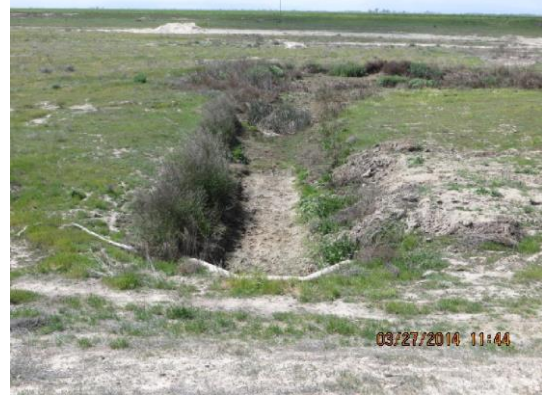
Photo 2 of 3 : UCIP_FA_2015_4491.jpg

Concrete headwall on WS toe.

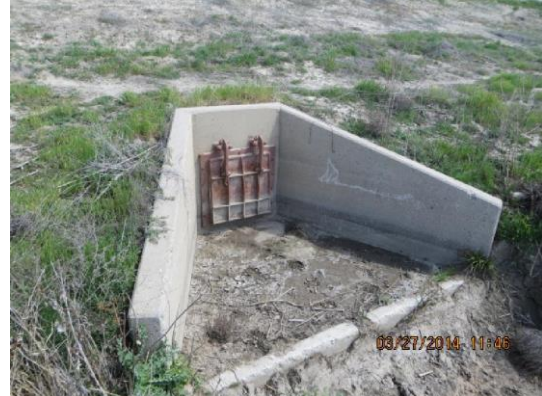
Photo 3 of 3 : UCIP_FA_2015_4492.jpg

Flapgate at concrete headwall on WS toe.

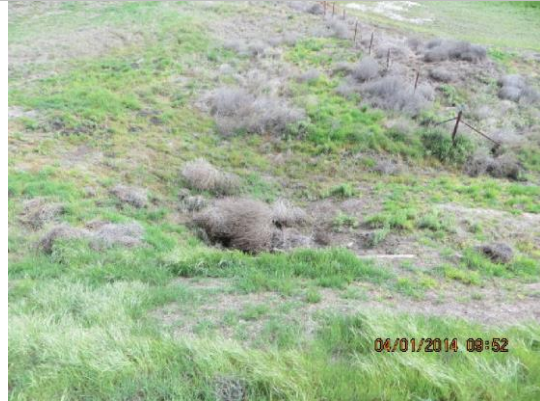
Photo 1 of 3 : UCIP_FA_2015_4025.jpg

Concrete headwall on LS toe.

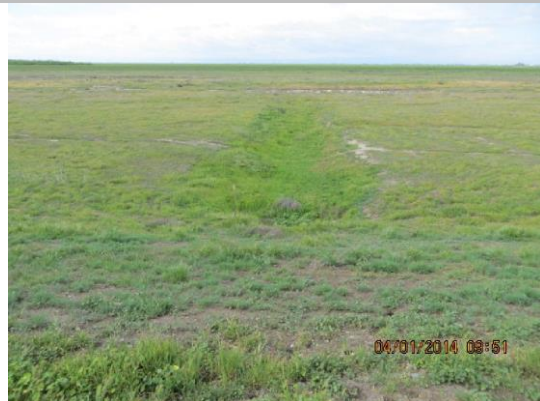
Photo 2 of 3 : UCIP_FA_2015_4026.jpg

Concrete headwall at channel on WS toe.

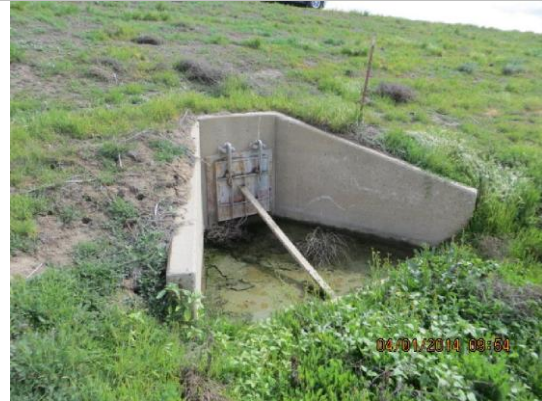
Photo 3 of 3 : UCIP_FA_2015_4027.jpg

LM Start	31.80	Rating **	M	Issue No.	1372 (cont)
LM End	31.80	Issue Type +	En	Location *	LS
Category	Supplemental			GPS Latitude/Longitude	
				Start	End
Item	DWR UCIP Field Study			36.995029 °	36.995029
				-120.408914 °	-120.408914
DWR ID					
Action/Comments					
Inspector Comments: FS_ID:39645					
DS_ID:19700					
EP_NO: N/A					
FS_HLM: 31.67					
Repair Type: Non-Urgent					
Crossing Status: Found

Flapgate on Concrete headwall at channel on WS toe.

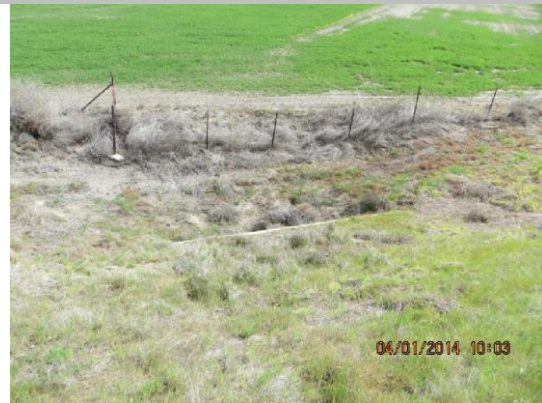
Photo 1 of 3 : UCIP_FA_2015_3721.jpg

LM Start	32.32	Rating **	M	Issue No.	1373
LM End	32.32	Issue Type +	En	Location *	LS
Category	Supplemental			GPS Latitude/Longitude	
				Start	End
Item	DWR UCIP Field Study			36.989435 °	36.989435 °
				-120.402626 °	-120.402626 °
DWR ID					
Action/Comments					
Inspector Comments: FS_ID:39646					
DS_ID:19701					
EP_NO: N/A					
FS_HLM: 32.219					
Repair Type: Non-Urgent					
Crossing Status: Found					
UCIP Comments: Some silt buildup inside culvert.					
FIELD_STRUCT_DESC: 30-inch square R.C.B.C. through the levee, 14.2 feet below the crown. Concrete "U" headwall on the waterward end. Flap gate on the waterward end. Concrete headwall on the landward end with flashboard attachment. (USACE-1967). This entry matches the Drainage or Irrigation Structure referenced in O&M manual (HLM 32.22).					
FS Date: 04/01/2014

Concrete headwall at inlet on LS toe.

Inspector Comments: FS_ID:39646
 DS_ID:19701
 EP_NO: N/A
 FS_HLM: 32.219
 Repair Type: Non-Urgent
 Crossing Status: Found
 UCIP Comments: Some silt buildup inside culvert.
 FIELD_STRUCT_DESC: 30-inch square R.C.B.C. through the levee, 14.2 feet below the crown. Concrete "U" headwall on the waterward end. Flap gate on the waterward end. Concrete headwall on the landward end with flashboard attachment. (USACE-1967). This entry matches the Drainage or Irrigation Structure referenced in O&M manual (HLM 32.22).
 FS Date: 04/01/2014

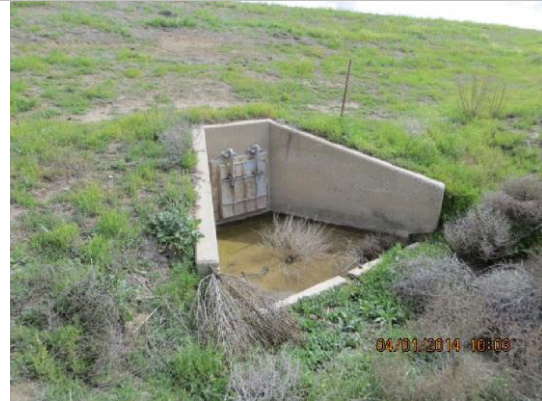
Photo 2 of 3 : UCIP_FA_2015_4028.jpg

Flapgate on Concrete headwall at WS toe.

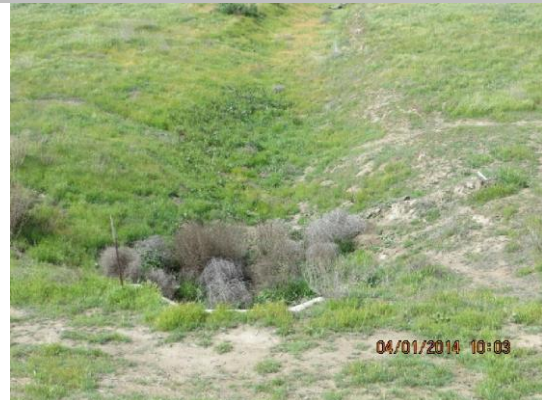
Photo 3 of 3 : UCIP_FA_2015_4029.jpg

Concrete headwall at outlet on WS toe.

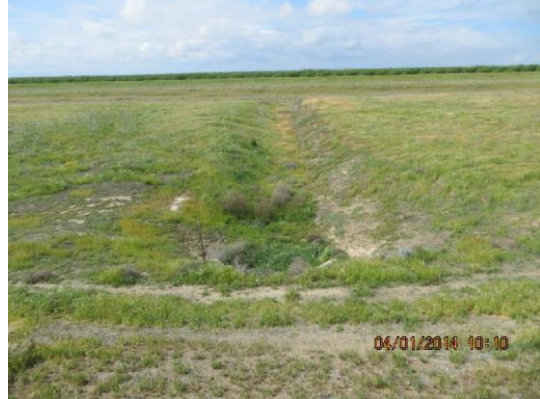
Photo 1 of 3 : UCIP_FA_2015_4057.jpg

LM Start	33.11	Rating **	M	Issue No.	1374
LM End	33.11	Issue Type +	En	Location *	LS
Category	Supplemental			GPS Latitude/Longitude	
				Start	End
Item	DWR UCIP Field Study			36.980861 °	36.980861 °
				-120.393116 °	-120.393116 °
DWR ID					
Action/Comments					
Inspector Comments: FS_ID:39647					
DS_ID:19702					
EP_NO: N/A					
FS_HLM: 33.009					
Repair Type: Non-Urgent					
Crossing Status: Found

Concrete headwall at WS toe.

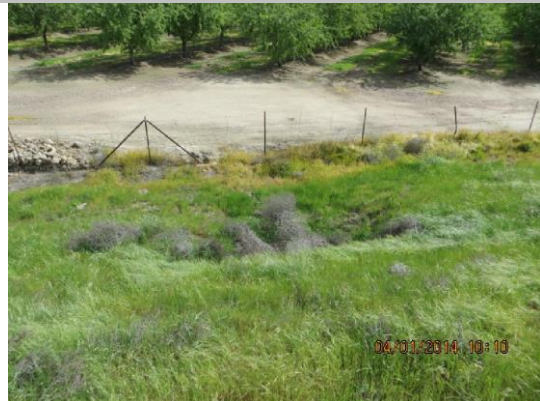
Photo 2 of 3 : UCIP_FA_2015_4058.jpg

Concrete headwall at inlet on LS toe.

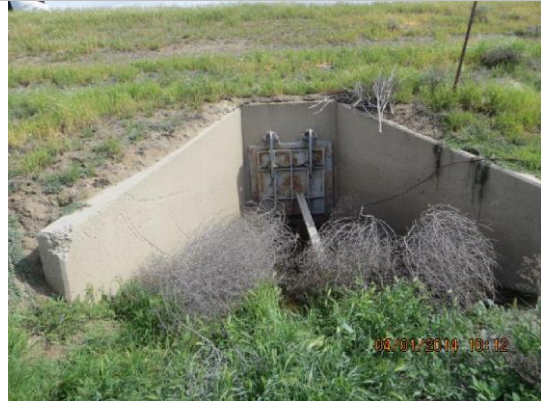
Photo 3 of 3 : UCIP_FA_2015_4059.jpg

Flapgate on Concrete headwall at WS toe.

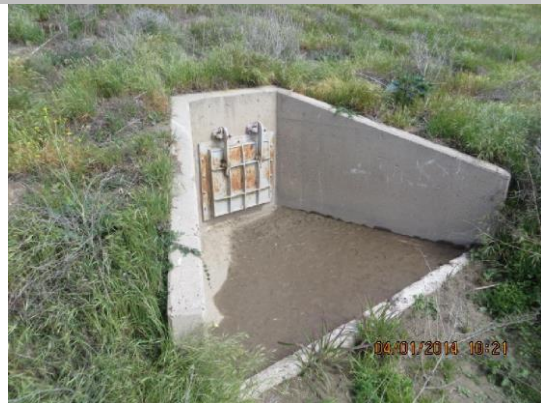
Photo 1 of 3 : UCIP_FA_2015_4060.jpg

LM Start	33.81	Rating **	M	Issue No.	1375
LM End	33.81	Issue Type +	En	Location *	LS
Category	Supplemental			GPS Latitude/Longitude	
				Start	End
Item	DWR UCIP Field Study			36.976808 °	36.976808 °
				-120.382593 °	-120.382593 °
DWR ID					
Action/Comments					
Inspector Comments: FS_ID:39648 DS_ID:19703 EP_NO: N/A FS_HLM: 33.708 Repair Type: Non-Urgent Crossing Status: Found UCIP Comments: Dense vegetation limits the inspector's visibility to identify signs of pipe failure (leaks) along the slopes. Recommend removing vegetation along pipe alignment to conduct proper inspection of structure. FIELD_STRUCT_DESC: 30-inch square R.C.B.C. through the levee, 13.9 feet below the crown. Concrete "U" headwall on the waterward end. Flap gate on the waterward end. Concrete headwall on the landward end. (USACE-1967). This entry matches the Drainage or Irrigation Structure referenced in O&M manual (HLM 33.72). FS Date: 04/01/2014

Flapgate on Concrete headwall at WS toe.

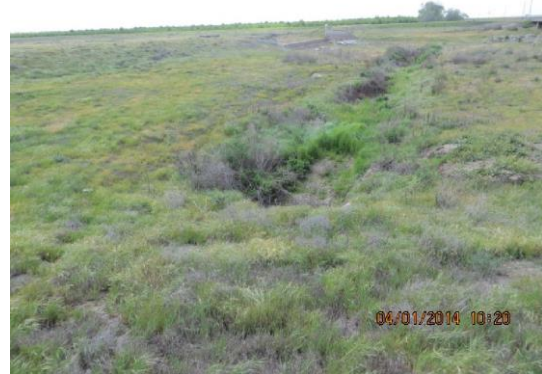
Photo 2 of 3 : UCIP_FA_2015_4061.jpg

Concrete headwall at WS toe.

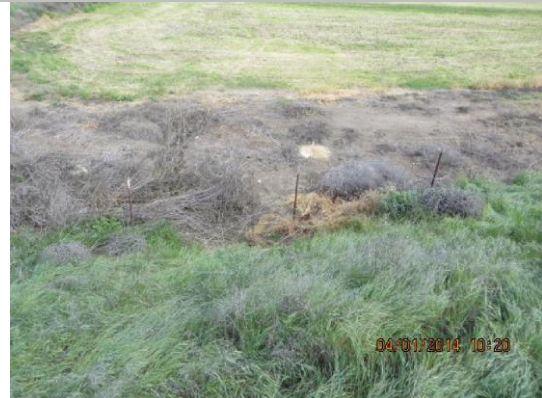
Photo 3 of 3 : UCIP_FA_2015_4062.jpg

Concrete headwall at LS toe.

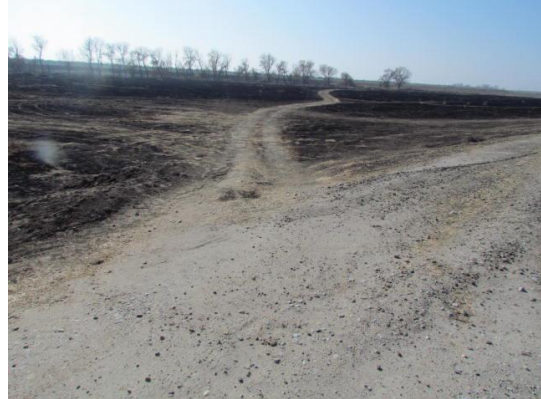
Photo 1 of 1 : FA_2015_NA0010_123_11_20150914_00010.jpg

LM Start	34.61	Rating **	M	Issue No.	11
LM End	34.61	Issue Type +	En	Location *	WS
Category	Earthen Levee			GPS Latitude/Longitude	
				Start	End
Item	Encroachments			36.978555 °	36.978555 °
				-120.368467 °	-120.368467 °
DWR ID	DWR_NA0010_05_s_2012_11				
Action/Comments					
Ramp Inspector Comments: Unauthorized ramp on waterside slope. Ramp is caused by vehicle traffic.

Looking southwest at unauthorized ramp on waterward slope.

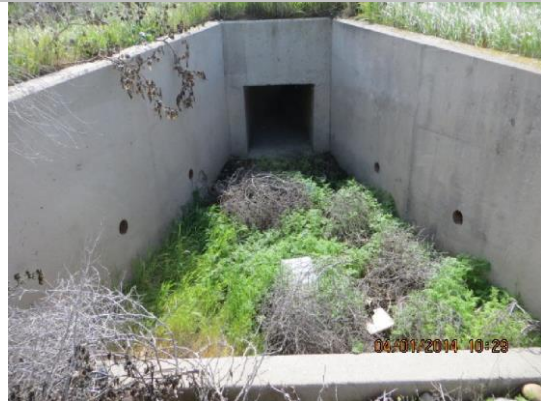
Photo 1 of 3 : UCIP_FA_2015_4063.jpg

LM Start	34.61	Rating **	M	Issue No.	1376
LM End	34.61	Issue Type +	En	Location *	WS
Category	Supplemental			GPS Latitude/Longitude	
				Start	End
Item	DWR UCIP Field Study			36.978593 °	36.978593 °
				-120.368511 °	-120.368511 °
DWR ID					
Action/Comments					
Inspector Comments: FS_ID:39649 DS_ID:19755 EP_NO: N/A FS_HLM: 34.508 Repair Type: Non-Urgent Crossing Status: Found UCIP Comments: Dense vegetation limits the inspector's visibility to identify signs of pipe failure (leaks) along the landward slope. Recommend removing vegetation along pipe alignment to conduct proper inspection of structure. Debris buildup visible on waterward headwall--recommend contacting owner to clear pipe. FIELD_STRUCT_DESC: 36-inch square R.C.B.C. through the levee, 9.7 feet below the crown. Slide gate in 56"X91" concrete riser unit on the waterward slope. Concrete "U" headwalls on both ends. Landside channel cobble revetted for 8.0 feet. (USACE-1967). [Chowchilla Canal Irrigation Structure] This entry matches the Drainage or Irrigation Structure referenced in O&M manual (HLM 34.51). FS Date: 04/01/2014

Concrete headwall at LS toe.

Inspector Comments: FS_ID:39649
 DS_ID:19755
 EP_NO: N/A
 FS_HLM: 34.508
 Repair Type: Non-Urgent
 Crossing Status: Found
 UCIP Comments: Dense vegetation limits the inspector's visibility to identify signs of pipe failure (leaks) along the landward slope. Recommend removing vegetation along pipe alignment to conduct proper inspection of structure. Debris buildup visible on waterward headwall--recommend contacting owner to clear pipe.
 FIELD_STRUCT_DESC: 36-inch square R.C.B.C. through the levee, 9.7 feet below the crown. Slide gate in 56"X91" concrete riser unit on the waterward slope. Concrete "U" headwalls on both ends. Landside channel cobble revetted for 8.0 feet. (USACE-1967). [Chowchilla Canal Irrigation Structure] This entry matches the Drainage or Irrigation Structure referenced in O&M manual (HLM 34.51).
 FS Date: 04/01/2014

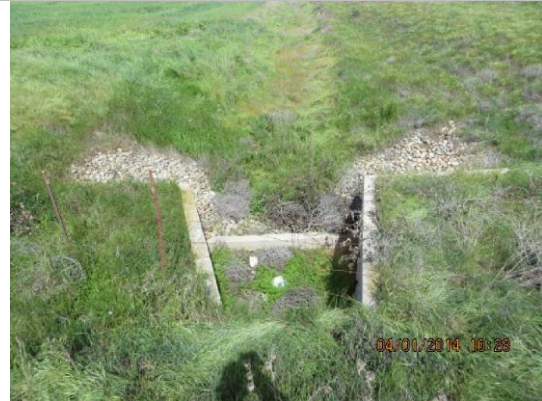
Photo 2 of 3 : UCIP_FA_2015_4064.jpg

Concrete headwall at LS toe.

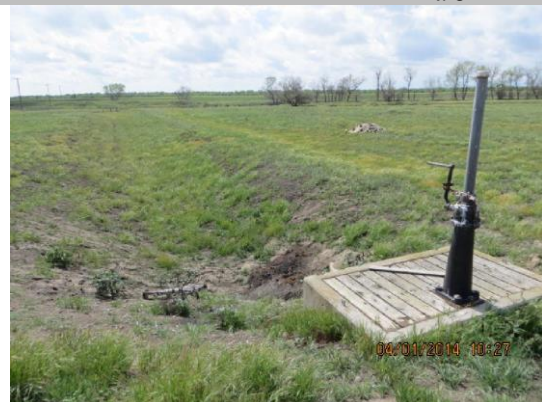
Photo 3 of 3 : UCIP_FA_2015_4065.jpg

Slide gate in concrete riser on WS shoulder.

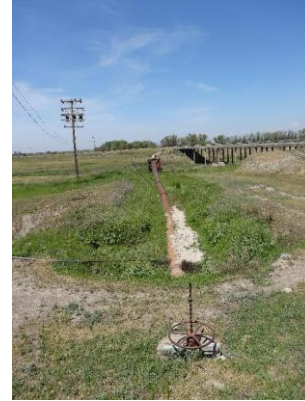
Photo 1 of 3 : UCIP_FA_2015_4920.jpg

Inspector Comments: FS_ID:39463
 DS_ID:19815
 EP_NO: N/A
 FS_HLM: 0.718
 Repair Type: Non-Urgent
 Crossing Status: Found
 UCIP Comments: Need to contact owner. Sediment buildup on landward side. Recommend removing sediment buildup on landward toe.
 FIELD_STRUCT_DESC: 24-inch CM pipe through levee, 7.2 feet below crown. Slide gate inside 36-inch CM pipe riser in the waterward slope. Pump on concrete structure in channel. Concrete headwall on both ends. (USACE-1967). This entry matches the Drainage or Irrigation Structure referenced in O&M manual (HLM 0.74).
 FS Date: 04/18/2014

View of waterward side.

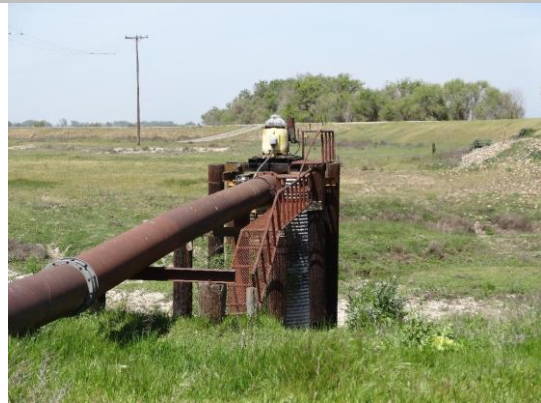
Photo 2 of 3 : UCIP_FA_2015_4942.jpg

Pump station visible on waterward side.

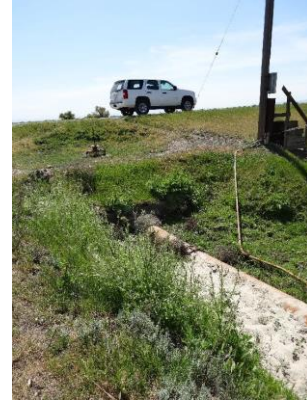
Photo 3 of 3 : UCIP_FA_2015_4943.jpg

View of slope on waterward side.

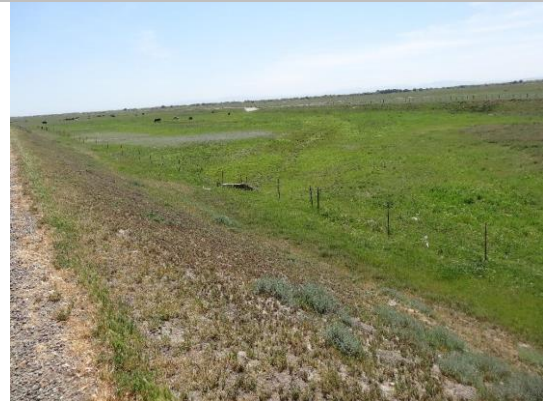
Photo 1 of 3 : UCIP_FA_2015_4944.jpg

LM Start	0.78	Rating **	M	Issue No.	1214
LM End	0.78	Issue Type +	En	Location *	LS
Category	Supplemental			GPS Latitude/Longitude	
				Start	End
Item	DWR UCIP Field Study			37.270460 °	37.270460 °
				-120.814290 °	-120.814290 °
DWR ID					
Action/Comments					
Inspector Comments: FS_ID:36565					
DS_ID:19816					
EP_NO: N/A					
FS_HLM: 0.846					
Repair Type: Non-Urgent					
Crossing Status: Found					
UCIP Comments: Landward side blocked--need to contact owner to determine status of crossing.					
FIELD_STRUCT_DESC: 24-inch CM pipe through levee, 16.2 feet below crown. Flap gate on the waterward end. Concrete "U" headwall on both ends. (USACE-1967). This entry matches the Drainage or Irrigation Structure referenced in O&M manual (HLM 0.86).					
FS Date: 04/18/2014

View of landward side.

Inspector Comments: FS_ID:36565
 DS_ID:19816
 EP_NO: N/A
 FS_HLM: 0.846
 Repair Type: Non-Urgent
 Crossing Status: Found
 UCIP Comments: Landward side blocked--need to contact owner to determine status of crossing.
 FIELD_STRUCT_DESC: 24-inch CM pipe through levee, 16.2 feet below crown. Flap gate on the waterward end. Concrete "U" headwall on both ends. (USACE-1967). This entry matches the Drainage or Irrigation Structure referenced in O&M manual (HLM 0.86).
 FS Date: 04/18/2014

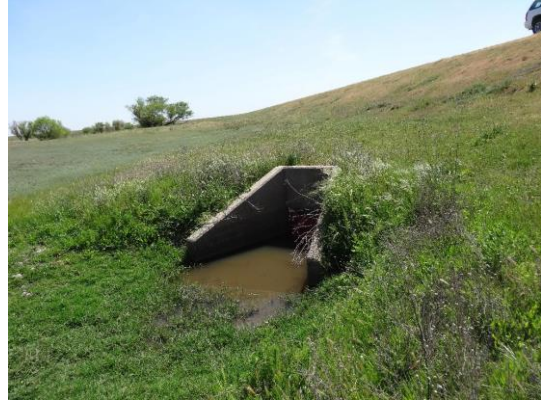
Photo 2 of 3 : UCIP_FA_2015_4945.jpg

Concrete structure located on waterward toe.

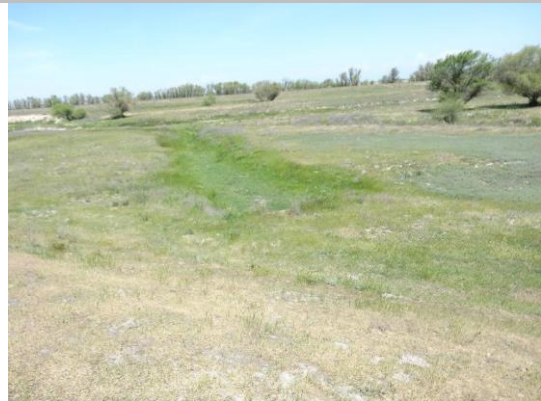
Photo 3 of 3 : UCIP_FA_2015_4946.jpg

Overview of waterward side.

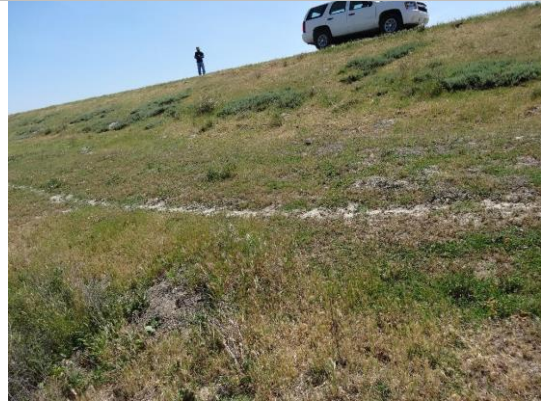
Photo 1 of 3 : UCIP_FA_2015_4947.jpg

LM Start	1.87	Rating **	M	Issue No.	1215
LM End	1.87	Issue Type +	En	Location *	LS
Category	Supplemental			GPS Latitude/Longitude	
				Start	End
Item	DWR UCIP Field Study			37.259312 °	37.259312 °
				-120.802863 °	-120.802863 °
DWR ID					
Action/Comments					
Inspector Comments: FS_ID:36566					
DS_ID:19817					
EP_NO: N/A					
FS_HLM: 1.936					
Repair Type: Non-Urgent					
Crossing Status: Found					
UCIP Comments: No access was available to landward side due to fence. Recommend removing some of the vegetation on waterward toe.					
FIELD_STRUCT_DESC: 24-inch CM pipe through levee, 13.5 feet below crown. Flap gate on the waterward end. Concrete headwall at both ends. (USACE-1967). This entry matches the Drainage or Irrigation Structure referenced in O&M manual (HLM 1.95).					
FS Date: 04/18/2014

View of waterward side.

Inspector Comments: FS_ID:36566
 DS_ID:19817
 EP_NO: N/A
 FS_HLM: 1.936
 Repair Type: Non-Urgent
 Crossing Status: Found
 UCIP Comments: No access was available to landward side due to fence. Recommend removing some of the vegetation on waterward toe.
 FIELD_STRUCT_DESC: 24-inch CM pipe through levee, 13.5 feet below crown. Flap gate on the waterward end. Concrete headwall at both ends. (USACE-1967). This entry matches the Drainage or Irrigation Structure referenced in O&M manual (HLM 1.95).
 FS Date: 04/18/2014

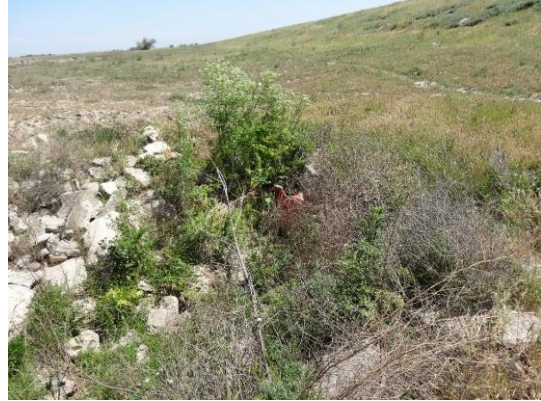
Photo 2 of 3 : UCIP_FA_2015_4948.jpg

Flap gate visible on waterward side.

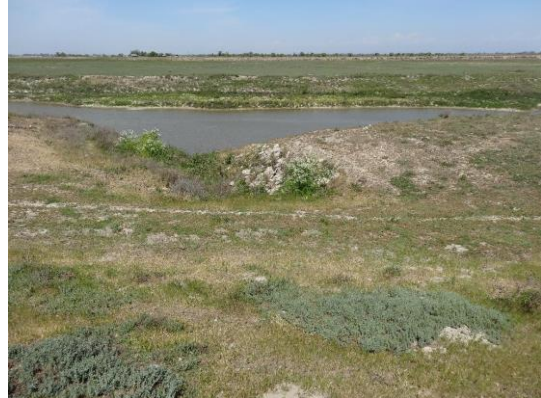
Photo 3 of 3 : UCIP_FA_2015_4949.jpg

View of waterward side.

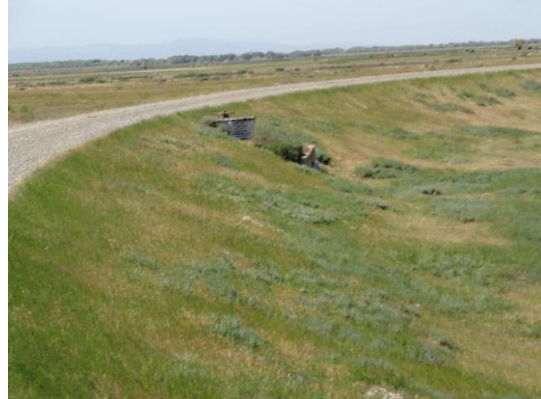
Photo 1 of 3 : UCIP_FA_2015_4950.jpg

LM Start	2.53	Rating **	M	Issue No.	1216
LM End	2.53	Issue Type +	En	Location *	LS
Category	Supplemental			GPS Latitude/Longitude	
				Start	End
Item	DWR UCIP Field Study			37.252948 °	37.252948 °
				-120.794352 °	-120.794352 °
DWR ID					
Action/Comments					
Inspector Comments: FS_ID:39464					
DS_ID:19818					
EP_NO: N/A					
FS_HLM: 2.595					
Repair Type: Non-Urgent					
Crossing Status: Found

View of waterward side.

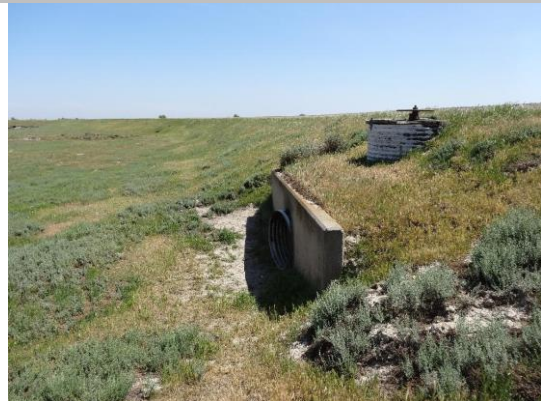
Photo 2 of 3 : UCIP_FA_2015_5052.jpg

CMP riser, concrete headwall, and pipe visible on waterward side.

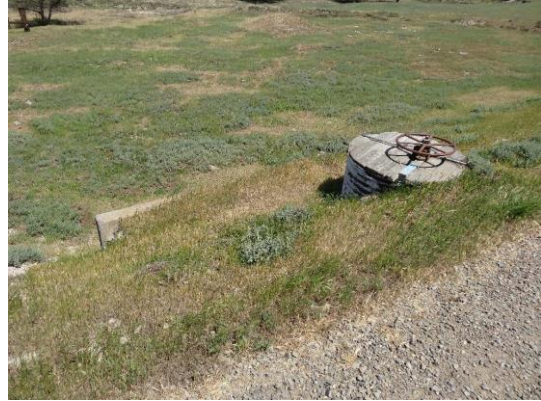
Photo 3 of 3 : UCIP_FA_2015_5053.jpg

View of waterward side.

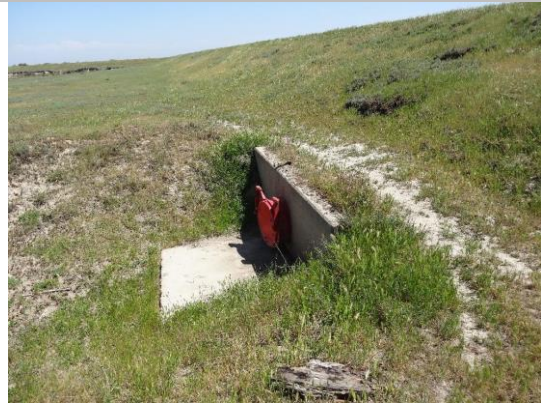
Photo 1 of 3 : UCIP_FA_2015_5054.jpg

LM Start	2.57	Rating **	M	Issue No.	1217
LM End	2.57	Issue Type +	En	Location *	LS
Category	Supplemental			GPS Latitude/Longitude	
				Start	End
Item	DWR UCIP Field Study			37.252743 °	37.252743 °
				-120.793756 °	-120.793756 °
DWR ID					
Action/Comments					
Inspector Comments: FS_ID:36568 DS_ID:19819 EP_NO: N/A FS_HLM: 2.631 Repair Type: Non-Urgent Crossing Status: Found UCIP Comments: Dense vegetation limits the inspector's visibility to identify signs of pipe condition on landward toe--headwall blocked by dense vegetation. Recommend removing vegetation from landward toe. FIELD_STRUCT_DESC: 24-inch CM pipe through levee, 9.2 feet below crown. Flap gate on the waterward end. Concrete headwall on both ends. (USACE-1967). This entry matches the Drainage or Irrigation Structure referenced in O&M manual (HLM 2.65). FS Date: 04/18/2014

View of concrete headwall, flap gate, and concrete apron located on waterward side.

Inspector Comments: FS_ID:36568
 DS_ID:19819
 EP_NO: N/A
 FS_HLM: 2.631
 Repair Type: Non-Urgent
 Crossing Status: Found
 UCIP Comments: Dense vegetation limits the inspector's visibility to identify signs of pipe condition on landward toe--headwall blocked by dense vegetation. Recommend removing vegetation from landward toe.
 FIELD_STRUCT_DESC: 24-inch CM pipe through levee, 9.2 feet below crown. Flap gate on the waterward end. Concrete headwall on both ends. (USACE-1967). This entry matches the Drainage or Irrigation Structure referenced in O&M manual (HLM 2.65).
 FS Date: 04/18/2014

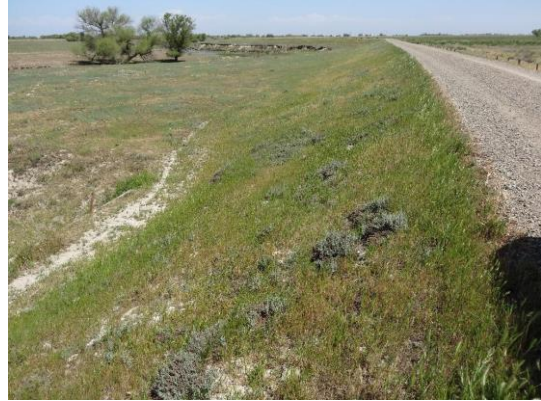
Photo 2 of 3 : UCIP_FA_2015_5055.jpg

View of waterward side.

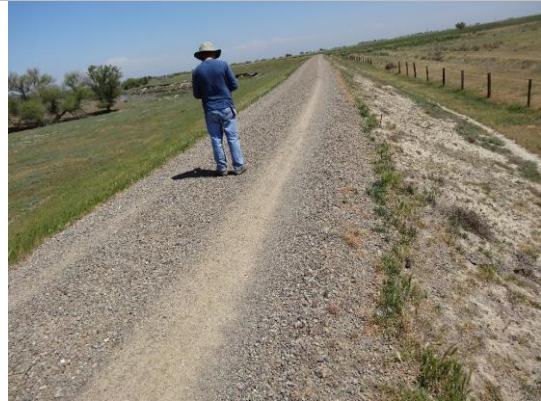
Photo 3 of 3 : UCIP_FA_2015_5056.jpg

Overview of levee crown at crossing.

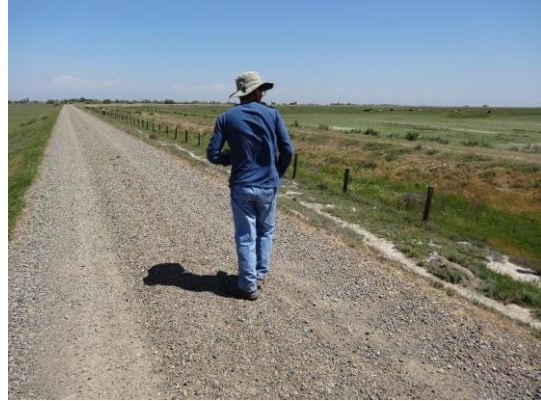
Photo 1 of 3 : UCIP_FA_2015_5057.jpg

LM Start	2.77	Rating **	M	Issue No.	1218
LM End	2.77	Issue Type +	En	Location *	LS
Category	Supplemental			GPS Latitude/Longitude	
				Start	End
Item	DWR UCIP Field Study			37.253020 °	37.253020 °
				-120.790219 °	-120.790219 °
DWR ID					
Action/Comments					
Inspector Comments: FS_ID:36569					
DS_ID:19820					
EP_NO: N/A					
FS_HLM: 2.835					
Repair Type: Non-Urgent					
Crossing Status: Found

Overview of levee crown at crossing.

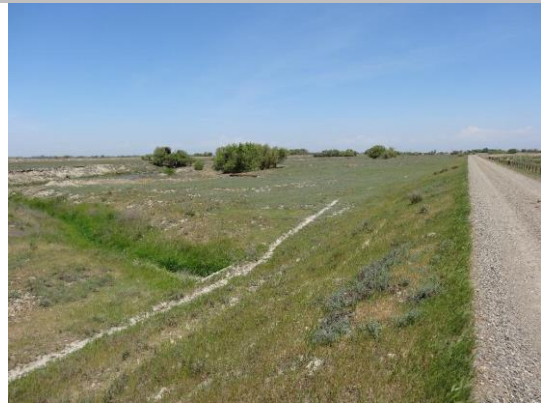
Photo 2 of 3 : UCIP_FA_2015_5058.jpg

View of waterward side.

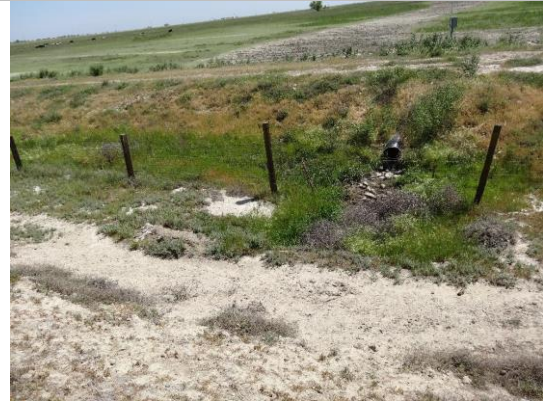
Photo 3 of 3 : UCIP_FA_2015_5059.jpg

LM Start	2.77	Rating **	M	Issue No.	1218 (cont)
LM End	2.77	Issue Type +	En	Location *	LS
Category	Supplemental			GPS Latitude/Longitude	
				Start	End
Item	DWR UCIP Field Study			37.253020 °	37.253020 °
				-120.790219 °	-120.790219 °
DWR ID					
Action/Comments					
Inspector Comments: FS_ID:36569					
DS_ID:19820					
EP_NO: N/A					
FS_HLM: 2.835					
Repair Type: Non-Urgent					
Crossing Status: Found

View of landward side.

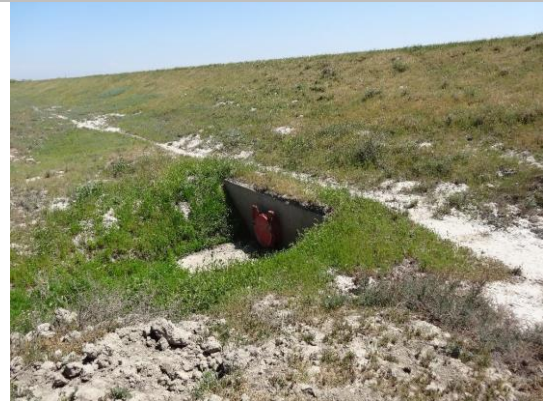
Photo 1 of 3 : UCIP_FA_2015_5060.jpg

LM Start	3.01	Rating **	M	Issue No.	1219
LM End	3.01	Issue Type +	En	Location *	LS
Category	Supplemental			GPS Latitude/Longitude	
				Start	End
Item	DWR UCIP Field Study			37.253811 °	37.253811 °
				-120.786059 °	-120.786059 °
DWR ID					
Action/Comments					
Inspector Comments: FS_ID:36583 DS_ID:19821 EP_NO: N/A FS_HLM: 3.073 Repair Type: Non-Urgent Crossing Status: Found UCIP Comments: Dense vegetation limits the inspector's visibility to identify signs of pipe condition on landward toe--headwall blocked by dense vegetation. Recommend removing vegetation from landward toe. FIELD_STRUCT_DESC: 24 inch CM pipe through levee, 11.2 feet below crown. Flap gate on the waterward end. Concrete headwall on both ends. (USACE-1967). This entry matches the Drainage or Irrigation Structure referenced in O&M manual (HLM 3.09). FS Date: 04/18/2014

Flap gate and concrete headwall visible on waterward side.

Inspector Comments: FS_ID:36583
 DS_ID:19821
 EP_NO: N/A
 FS_HLM: 3.073
 Repair Type: Non-Urgent
 Crossing Status: Found
 UCIP Comments: Dense vegetation limits the inspector's visibility to identify signs of pipe condition on landward toe--headwall blocked by dense vegetation. Recommend removing vegetation from landward toe.
 FIELD_STRUCT_DESC: 24 inch CM pipe through levee, 11.2 feet below crown. Flap gate on the waterward end. Concrete headwall on both ends. (USACE-1967). This entry matches the Drainage or Irrigation Structure referenced in O&M manual (HLM 3.09).
 FS Date: 04/18/2014

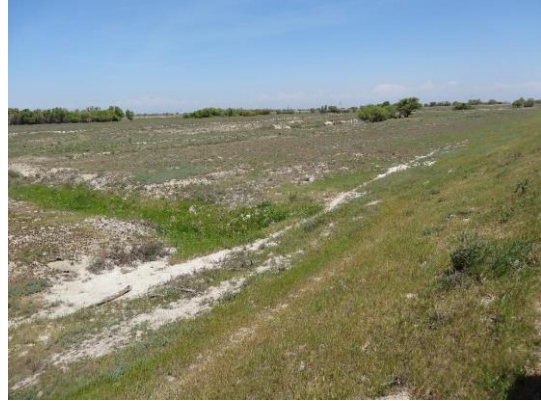
Photo 2 of 3 : UCIP_FA_2015_5061.jpg

View of waterward side.

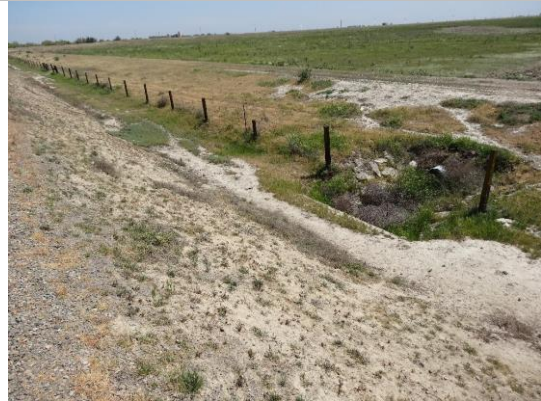
Photo 3 of 3 : UCIP_FA_2015_5062.jpg

View of landward side.

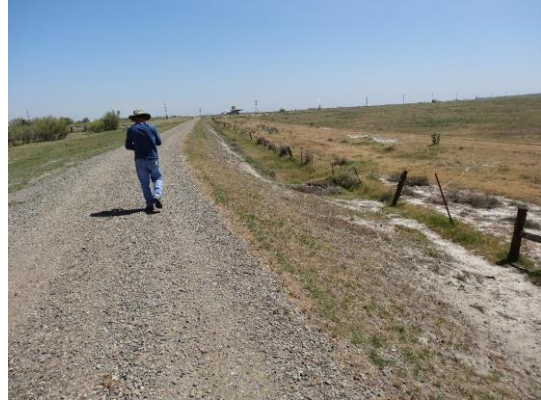
Photo 1 of 3 : UCIP_FA_2015_5063.jpg

LM Start	3.21	Rating **	M	Issue No.	1220
LM End	3.21	Issue Type +	En	Location *	LS
Category	Supplemental			GPS Latitude/Longitude	
				Start	End
Item	DWR UCIP Field Study			37.253513 °	37.253513 °
				-120.782509 °	-120.782509 °
DWR ID					
Action/Comments					
Inspector Comments: FS_ID:36584					
DS_ID:19822					
EP_NO: N/A					
FS_HLM: 3.267					
Repair Type: Non-Urgent					
Crossing Status: Found

Overview of levee crown and landward side.

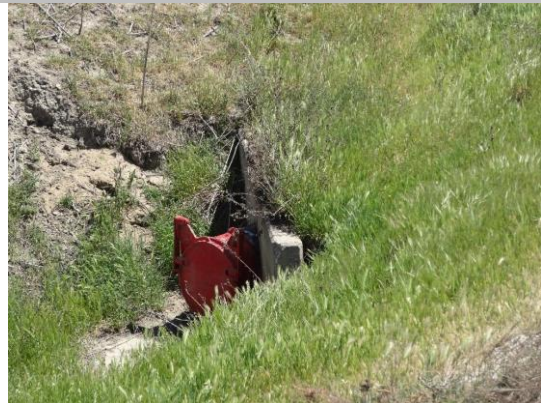
Photo 2 of 3 : UCIP_FA_2015_5064.jpg

Crossing goes through the levee at an angle. Flap gate visible on waterward side.

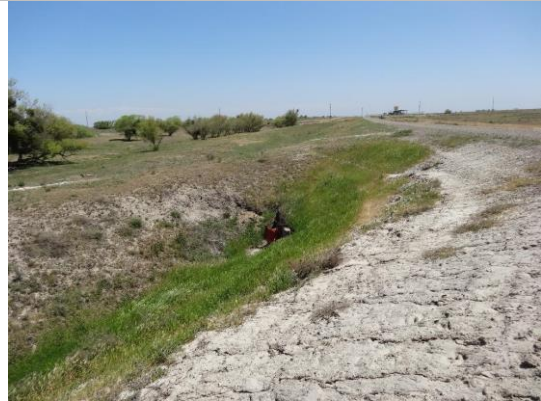
Photo 3 of 3 : UCIP_FA_2015_5065.jpg

LM Start	3.21	Rating **	M	Issue No.	1220 (cont)
LM End	3.21	Issue Type +	En	Location *	LS
Category	Supplemental			GPS Latitude/Longitude	
				Start	End
Item	DWR UCIP Field Study			37.253513 °	37.253513
				-120.782509 °	-120.782509
DWR ID					
Action/Comments					
Inspector Comments: FS_ID:36584					
DS_ID:19822					
EP_NO: N/A					
FS_HLM: 3.267					
Repair Type: Non-Urgent					
Crossing Status: Found

View of waterward side.

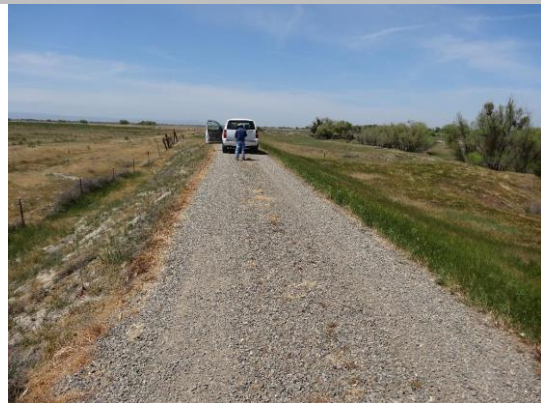
Photo 1 of 3 : UCIP_FA_2015_5066.jpg

LM Start	3.38	Rating **	M	Issue No.	1221
LM End	3.38	Issue Type +	En	Location *	LS
Category	Supplemental			GPS Latitude/Longitude	
				Start	End
Item	DWR UCIP Field Study			37.252152 °	37.252152 °
				-120.779969 °	-120.779969 °
DWR ID					
Action/Comments					
Inspector Comments: FS_ID:36585 DS_ID:19823 EP_NO: N/A FS_HLM: 3.44 Repair Type: Non-Urgent Crossing Status: Found UCIP Comments: Alignment of crossing unknown--altered crossing. No headwall found on landward side only siphon breaker found a short distance from landward toe. Tall grass observed on waterward slope and some burrow activity also noticed. Need to contact owner to determine alignment of crossing and status of crossing. FIELD_STRUCT_DESC: 36-inch CM pipe through levee, 15.7 feet below crown. Flap gate on the waterward end. Concrete "U" headwall on both ends. BM stamped 9770-152 on top of the headwall on the waterward side. (USACE-1967). This entry matches the Drainage or Irrigation Structure referenced in O&M manual (HLM 3.43). FS Date: 04/18/2014

Overview of levee crown at crossing.

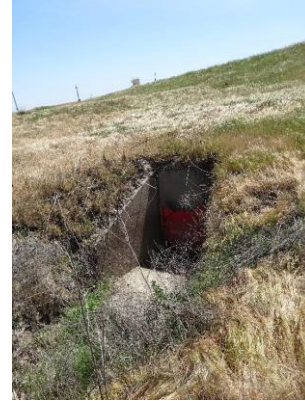
Photo 2 of 3 : UCIP_FA_2015_5067.jpg

LM Start	3.38	Rating **	M	Issue No.	1221 (cont)
LM End	3.38	Issue Type +	En	Location *	LS
Category	Supplemental			GPS Latitude/Longitude	
				Start	End
Item	DWR UCIP Field Study			37.252152 °	37.252152 °
				-120.779969 °	-120.779969 °
DWR ID					
Action/Comments					
Inspector Comments: FS_ID:36585 DS_ID:19823 EP_NO: N/A FS_HLM: 3.44 Repair Type: Non-Urgent Crossing Status: Found UCIP Comments: Alignment of crossing unknown--altered crossing. No headwall found on landward side only siphon breaker found a short distance from landward toe. Tall grass observed on waterward slope and some burrow activity also noticed. Need to contact owner to determine alignment of crossing and status of crossing. FIELD_STRUCT_DESC: 36-inch CM pipe through levee, 15.7 feet below crown. Flap gate on the waterward end. Concrete "U" headwall on both ends. BM stamped 9770-152 on top of the headwall on the waterward side. (USACE-1967). This entry matches the Drainage or Irrigation Structure referenced in O&M manual (HLM 3.43). FS Date: 04/18/2014

Flap gate and concrete headwall visible on waterward side.

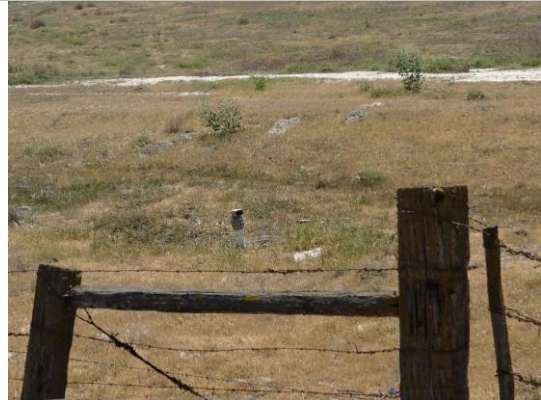
Photo 3 of 3 : UCIP_FA_2015_5105.jpg

View of landward side. No signs of concrete headwall only siphon breaker visible on landward side.

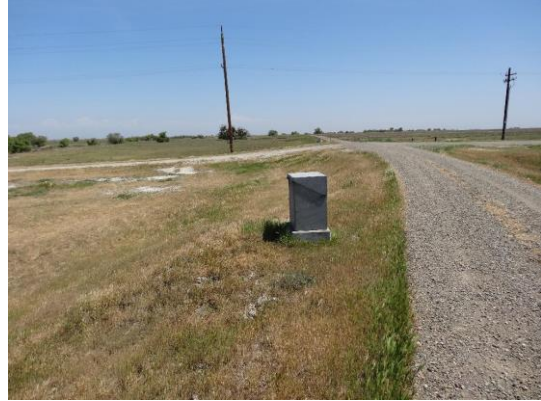
Photo 1 of 3 : UCIP_FA_2015_6213.jpg

LM Start	3.41	Rating **	M	Issue No.	1222
LM End	3.41	Issue Type +	En	Location *	LS
Category	Supplemental			GPS Latitude/Longitude	
				Start	End
Item	DWR UCIP Field Study			37.251902 °	37.251902 °
				-120.779391 °	-120.779391 °
DWR ID					
Action/Comments					
Inspector Comments: FS_ID:39482					
DS_ID:19824					
EP_NO: 6965					
FS_HLM: 3.477					
Repair Type: Non-Urgent					
Crossing Status: Indicator Found

Metal box located on waterward shoulder.

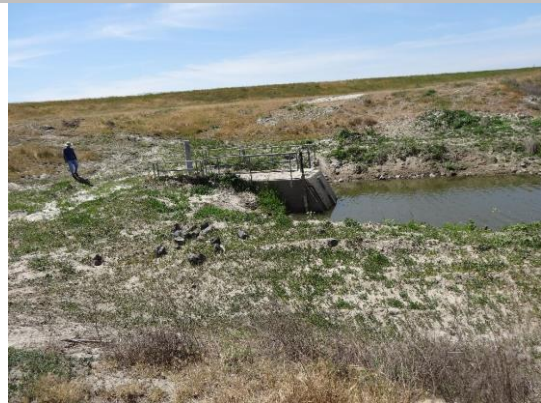
Photo 2 of 3 : UCIP_FA_2015_6214.jpg

View of structure located on waterward side.

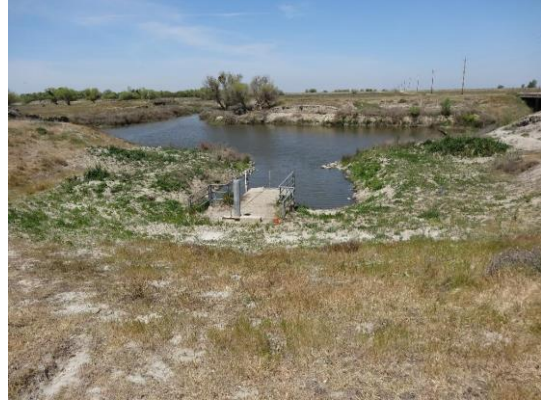
Photo 3 of 3 : UCIP_FA_2015_6215.jpg

LM Start	3.41	Rating **	M	Issue No.	1222 (cont)
LM End	3.41	Issue Type +	En	Location *	LS
Category	Supplemental			GPS Latitude/Longitude	
				Start	End
Item	DWR UCIP Field Study			37.251902 °	37.251902 °
				-120.779391 °	-120.779391 °
DWR ID					
Action/Comments					
Inspector Comments: FS_ID:39482					
DS_ID:19824					
EP_NO: 6965					
FS_HLM: 3.477					
Repair Type: Non-Urgent					
Crossing Status: Indicator Found

View of waterward side.

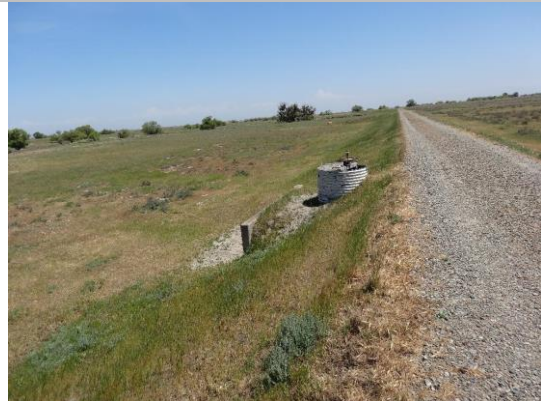
Photo 1 of 3 : UCIP_FA_2015_5106.jpg

LM Start	3.46	Rating **	M	Issue No.	1223
LM End	3.46	Issue Type +	En	Location *	LS
Category	Supplemental			GPS Latitude/Longitude	
				Start	End
Item	DWR UCIP Field Study			37.251687 °	37.251687 °
				-120.778534 °	-120.778534 °
DWR ID					
Action/Comments					
Inspector Comments: FS_ID:39465 DS_ID:19825 EP_NO: N/A FS_HLM: 3.528 Repair Type: Non-Urgent Crossing Status: Found UCIP Comments: Sediment buildup inside pipe visible from landward side. Excess soil is also present on landward toe partially blocking concrete headwall and inlet. Recommend removing soil from landward toe and clear buildup inside. FIELD_STRUCT_DESC: 36-inch CM pipe through the levee, 6.8 feet below crown. Slide gate in 48-inch CM pipe riser in the waterward slope. Concrete headwall on both ends. Pipe connects to 30-inch steel drainpipe on waterward side. Drainpipe extends to pump on waterward side, on support platform in channel. (USACE-1967). This entry matches the Drainage or Irrigation Structure referenced in O&M manual (HLM 3.54). Extension drainpipe and pump installed under Permit No. 12527 (1980). FS Date: 04/18/2014

View of waterward side--cmp riser and concrete headwall visible.

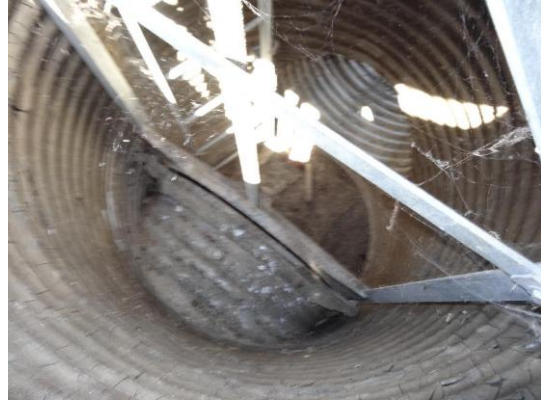
Photo 2 of 3 : UCIP_FA_2015_5107.jpg

Item	DWR UCIP Field Study			37.251687 °	37.251687 °	
				-120.778534 °	-120.778534 °	
DWR ID						
Action/Comments						
Inspector Comments: FS_ID:39465 DS_ID:19825 EP_NO: N/A FS_HLM: 3.528 Repair Type: Non-Urgent Crossing Status: Found UCIP Comments: Sediment buildup inside pipe visible from landward side. Excess soil is also present on landward toe partially blocking concrete headwall and inlet. Recommend removing soil from landward toe and clear buildup inside. FIELD_STRUCT_DESC: 36-inch CM pipe through the levee, 6.8 feet below crown. Slide gate in 48-inch CM pipe riser in the waterward slope. Concrete headwall on both ends. Pipe connects to 30-inch steel drainpipe on waterward side. Drainpipe extends to pump on waterward side, on support platform in channel. (USACE-1967). This entry matches the Drainage or Irrigation Structure referenced in O&M manual (HLM 3.54). Extension drainpipe and pump installed under Permit No. 12527 (1980). FS Date: 04/18/2014

Inside view of cmp riser located on waterward slope.

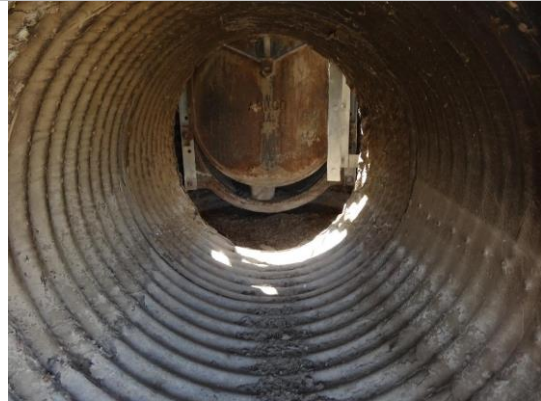
Photo 3 of 3 : UCIP_FA_2015_5108.jpg

Item	DWR UCIP Field Study			37.251687 °	37.251687 °	
				-120.778534 °	-120.778534 °	
DWR ID						
Action/Comments						
Inspector Comments: FS_ID:39465 DS_ID:19825 EP_NO: N/A FS_HLM: 3.528 Repair Type: Non-Urgent Crossing Status: Found UCIP Comments: Sediment buildup inside pipe visible from landward side. Excess soil is also present on landward toe partially blocking concrete headwall and inlet. Recommend removing soil from landward toe and clear buildup inside. FIELD_STRUCT_DESC: 36-inch CM pipe through the levee, 6.8 feet below crown. Slide gate in 48-inch CM pipe riser in the waterward slope. Concrete headwall on both ends. Pipe connects to 30-inch steel drainpipe on waterward side. Drainpipe extends to pump on waterward side, on support platform in channel. (USACE-1967). This entry matches the Drainage or Irrigation Structure referenced in O&M manual (HLM 3.54). Extension drainpipe and pump installed under Permit No. 12527 (1980). FS Date: 04/18/2014

Inside view of pipe from waterward side.

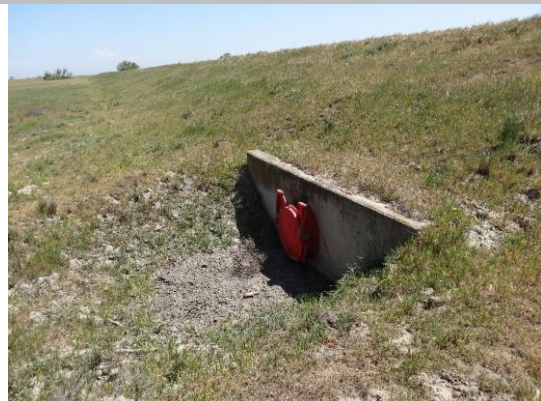
Photo 1 of 3 : UCIP_FA_2015_5223.jpg

LM Start	3.69	Rating **	M	Issue No.	1224
LM End	3.69	Issue Type +	En	Location *	LS
Category	Supplemental			GPS Latitude/Longitude	
				Start	End
Item	DWR UCIP Field Study			37.251199 °	37.251199 °
				-120.774474 °	-120.774474 °
DWR ID					
Action/Comments					
Inspector Comments: FS_ID:39466 DS_ID:19826 EP_NO: N/A FS_HLM: 3.755 Repair Type: Non-Urgent Crossing Status: Found UCIP Comments: Sediment buildup inside crossing and is visible from landward side. Recommend clearing sediment buildup inside pipe and check wall integrity to determine condition. FIELD_STRUCT_DESC: 24-inch CM pipe through levee, 7.0 feet below crown. Flap gate on the waterward end. Concrete headwall on both ends. (USACE-1967). This entry matches the Drainage or Irrigation Structure referenced in O&M manual (HLM 3.77). FS Date: 04/18/2014

View of flap gate visible on waterward side.

Inspector Comments: FS_ID:39466
 DS_ID:19826
 EP_NO: N/A
 FS_HLM: 3.755
 Repair Type: Non-Urgent
 Crossing Status: Found
 UCIP Comments: Sediment buildup inside crossing and is visible from landward side. Recommend clearing sediment buildup inside pipe and check wall integrity to determine condition.
 FIELD_STRUCT_DESC: 24-inch CM pipe through levee, 7.0 feet below crown. Flap gate on the waterward end. Concrete headwall on both ends. (USACE-1967). This entry matches the Drainage or Irrigation Structure referenced in O&M manual (HLM 3.77).
 FS Date: 04/18/2014

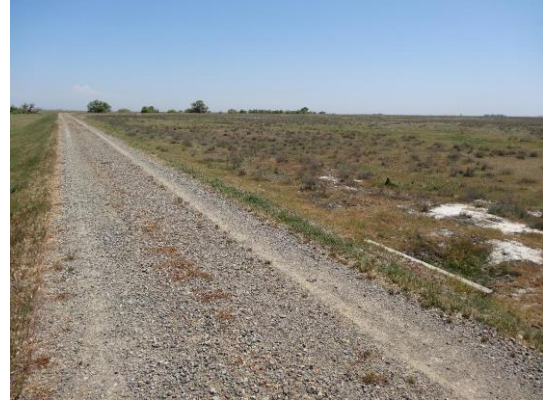
Photo 2 of 3 : UCIP_FA_2015_5224.jpg

View of landward side.

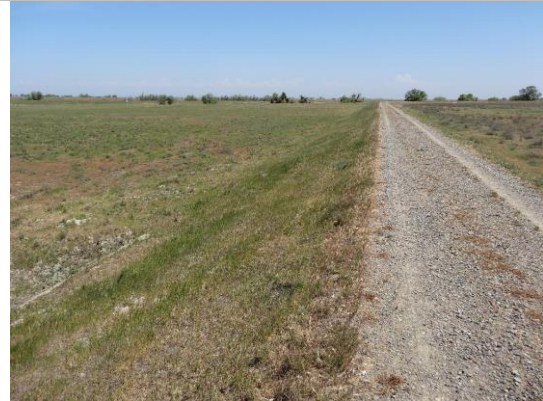
Photo 3 of 3 : UCIP_FA_2015_5225.jpg

View of waterward side.

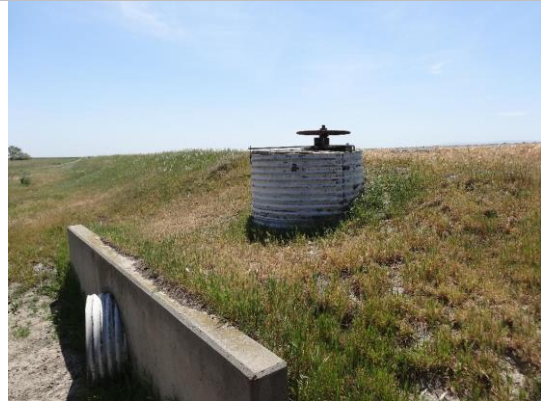
Photo 1 of 2 : UCIP_FA_2015_5221.jpg

LM Start	3.89	Rating **	M	Issue No.	1225
LM End	3.89	Issue Type +	En	Location *	LS
Category	Supplemental			GPS Latitude/Longitude	
				Start	End
Item	DWR UCIP Field Study			37.250742 °	37.250742 °
				-120.771026 °	-120.771026 °
DWR ID					
Action/Comments					
Inspector Comments: FS_ID:39467					
DS_ID:19827					
EP_NO: N/A					
FS_HLM: 3.956					
Repair Type: Non-Urgent					
Crossing Status: Found

Slide gate inside CMP riser visible on waterward slope.

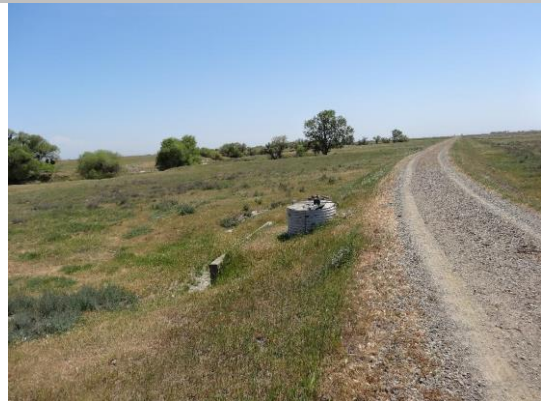
Photo 2 of 2 : UCIP_FA_2015_5222.jpg

View of waterward side.

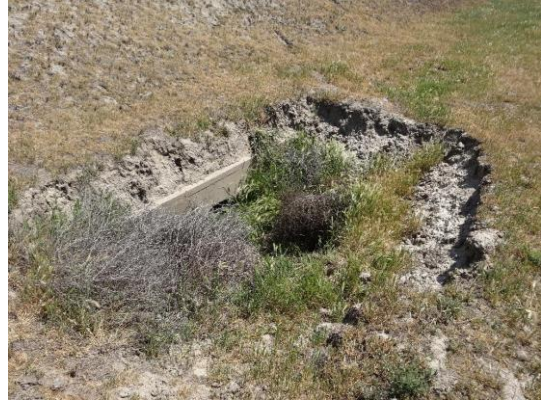
Photo 1 of 3 : UCIP_FA_2015_5226.jpg

LM Start	4.09	Rating **	M	Issue No.	1226
LM End	4.09	Issue Type +	En	Location *	LS
Category	Supplemental			GPS Latitude/Longitude	
				Start	End
Item	DWR UCIP Field Study			37.248353 °	37.248353 °
				-120.768922 °	-120.768922 °
DWR ID					
Action/Comments					
Inspector Comments: FS_ID:36606					
DS_ID:19828					
EP_NO: N/A					
FS_HLM: 4.157					
Repair Type: Non-Urgent					
Crossing Status: Found

Concrete hedwall visible on landward side.

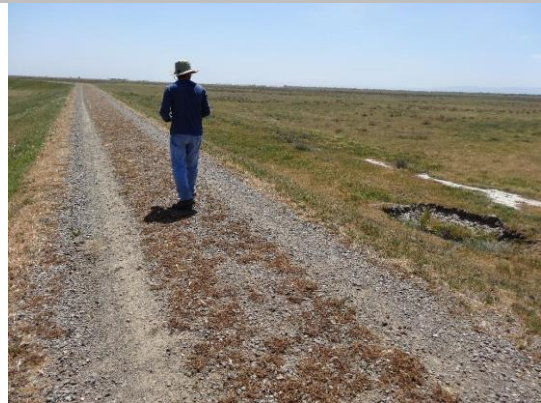
Photo 2 of 3 : UCIP_FA_2015_5227.jpg

Overview of levee crown at crossing.

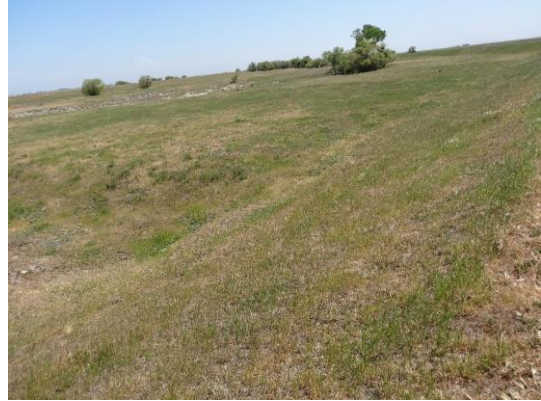
Photo 3 of 3 : UCIP_FA_2015_5228.jpg

LM Start	4.09	Rating **	M	Issue No.	1226 (cont)
LM End	4.09	Issue Type +	En	Location *	LS
Category	Supplemental			GPS Latitude/Longitude	
				Start	End
Item	DWR UCIP Field Study			37.248353 °	37.248353 °
				-120.768922 °	-120.768922 °
DWR ID					
Action/Comments					
Inspector Comments: FS_ID:36606					
DS_ID:19828					
EP_NO: N/A					
FS_HLM: 4.157					
Repair Type: Non-Urgent					
Crossing Status: Found

View of waterward side.

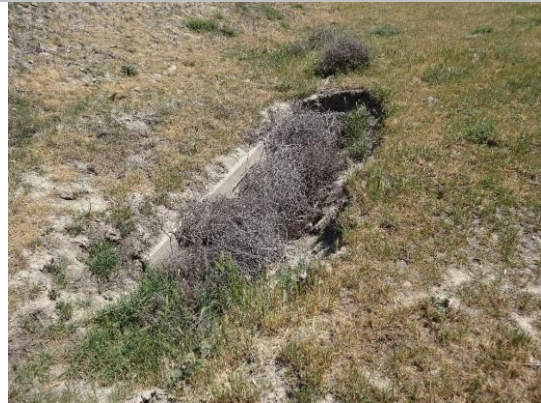
Photo 1 of 2 : UCIP_FA_2015_5229.jpg

LM Start	4.33	Rating **	M	Issue No.	1227
LM End	4.33	Issue Type +	En	Location *	LS
Category	Supplemental			GPS Latitude/Longitude	
				Start	End
Item	DWR UCIP Field Study			37.246459 °	37.246459 °
				-120.765470 °	-120.765470 °
DWR ID					
Action/Comments					
Inspector Comments: FS_ID:36607 DS_ID:19829 EP_NO: N/A FS_HLM: 4.394 Repair Type: Non-Urgent Crossing Status: Found UCIP Comments: Dense vegetation limits the inspector's visibility to identify signs of pipe condition on landward toe--headwall blocked by dense vegetation. Recommend removing vegetation from landward toe. FIELD_STRUCT_DESC: 24-inch CM pipe through levee, 11.3 feet below crown. Flap gate on the waterward end. Concrete headwall on both ends. (USACE-1967). This entry matches the Drainage or Irrigation Structure referenced in O&M manual (HLM 4.41). FS Date: 04/18/2014

View of landward side--concrete headwall visible through dense vegetation.

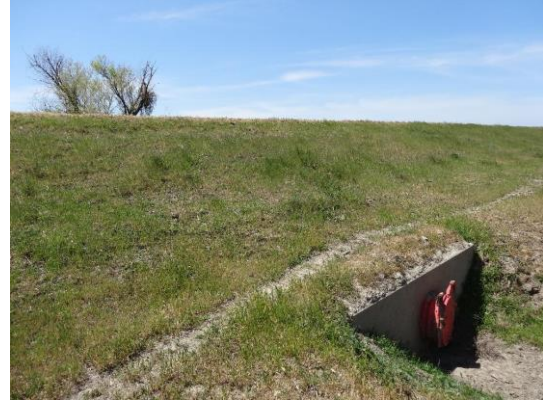
Photo 2 of 2 : UCIP_FA_2015_5230.jpg

LM Start	4.33	Rating **	M	Issue No.	1227 (cont)	
LM End	4.33	Issue Type +	En	Location *	LS	
Category	Supplemental			GPS Latitude/Longitude		
				Start	End	
Item	DWR UCIP Field Study			37.246459 °	37.246459 °	
				-120.765470 °	-120.765470 °	
DWR ID						
Action/Comments						
Inspector Comments: FS_ID:36607 DS_ID:19829 EP_NO: N/A FS_HLM: 4.394 Repair Type: Non-Urgent Crossing Status: Found UCIP Comments: Dense vegetation limits the inspector's visibility to identify signs of pipe condition on landward toe--headwall blocked by dense vegetation. Recommend removing vegetation from landward toe. FIELD_STRUCT_DESC: 24-inch CM pipe through levee, 11.3 feet below crown. Flap gate on the waterward end. Concrete headwall on both ends. (USACE-1967). This entry matches the Drainage or Irrigation Structure referenced in O&M manual (HLM 4.41). FS Date: 04/18/2014

View of waterward side--concrete headwall and flap gate visible.

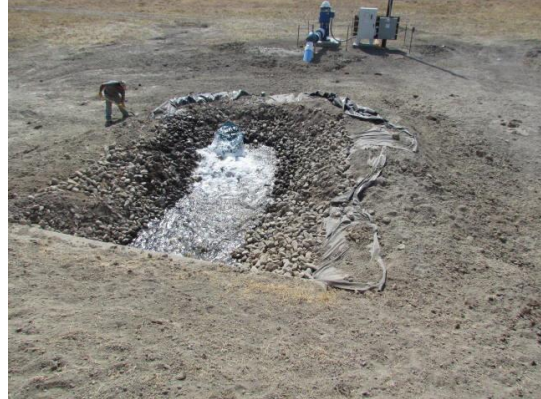
Photo 1 of 3 : FA_2015_NA0010_124_71_20151013_00031.jpg

LM Start	4.62	Rating **	U	Issue No.	71 (cont)
LM End	4.62	Issue Type +	En	Location *	LS

Looking at dyke around drainage pipe at landward toe.

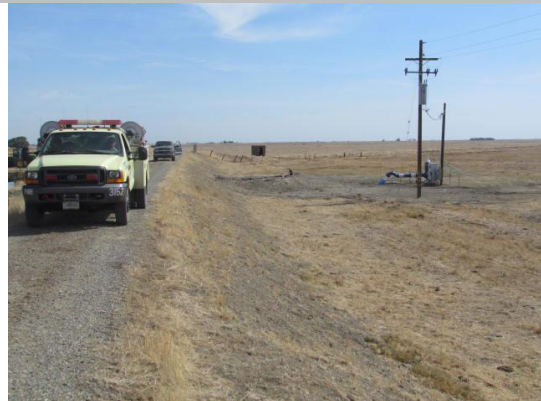
Photo 2 of 3 : FA_2015_NA0010_124_71_20151013_00032.jpg

Looking south at dyke around drainage pipe at landward toe.

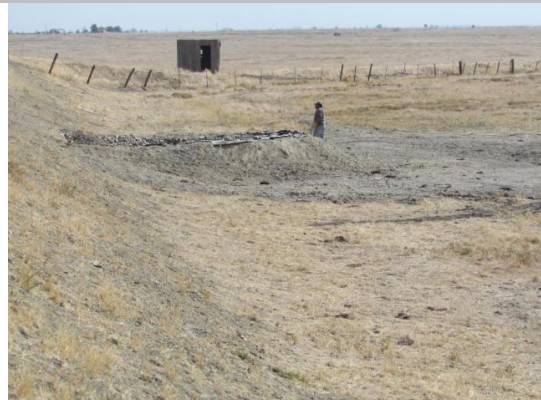
Photo 3 of 3 : FA_2015_NA0010_124_71_20151013_00033.jpg

Looking south at dyke around drainage pipe at landward toe.

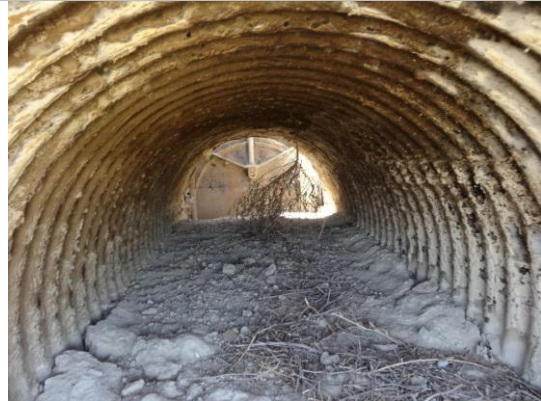
Photo 1 of 3 : UCIP_FA_2015_5231.jpg

Inside view of pipe from waterward side.
