**Flood Control Project Maintenance
Levee Inspections**

Fall 2015 Levee Maintenance Deficiency Summary Report

San Joaquin River Basin

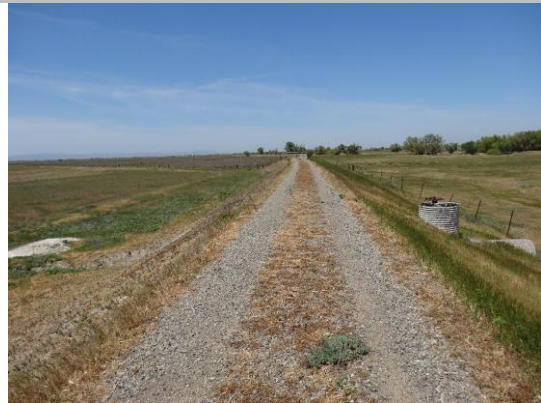
Photo 2 of 3 : UCIP_FA_2015_5232.jpg

Overview of levee crown at crossing.

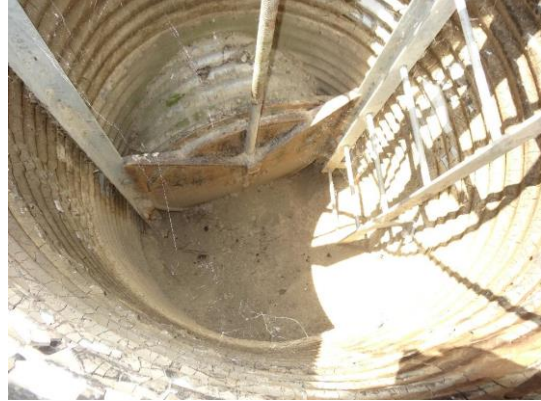
Photo 3 of 3 : UCIP_FA_2015_5233.jpg

Inside view of CMP riser located on waterward.

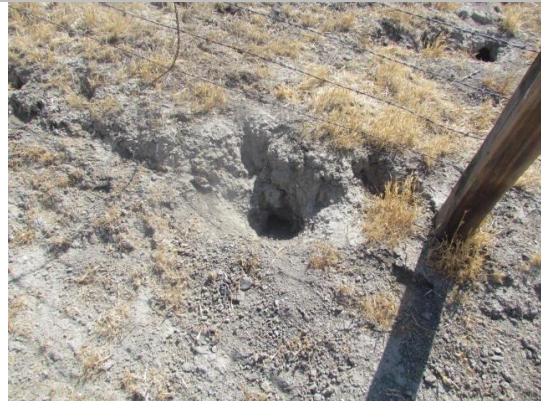
Photo 1 of 2 : FA_2015_NA0010_124_10_20150914_00013.jpg

LM Start	4.66	Rating **	M	Issue No.	10
LM End	4.66	Issue Type +	Ma	Location *	LS
Category	Earthen Levee			GPS Latitude/Longitude	
				Start	End
Item	Animal Control			37.243540 °	37.243540 °
				-120.760782 °	-120.760782 °
DWR ID	DWR_NA0010_06_s_2012_10				
Action/Comments					
No rodents visible, but rodent burrows visible; need to backfill and compact or grout burrows. Inspector Comments: Rodent holes next to fence post on landward slope.

Looking at rodent hole along fence line on landward slope.

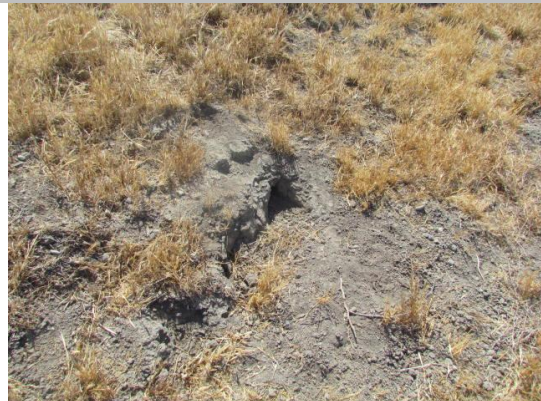
Photo 2 of 2 : FA_2015_NA0010_124_10_20150914_00014.jpg

Looking at typical rodent holes on landward slope.

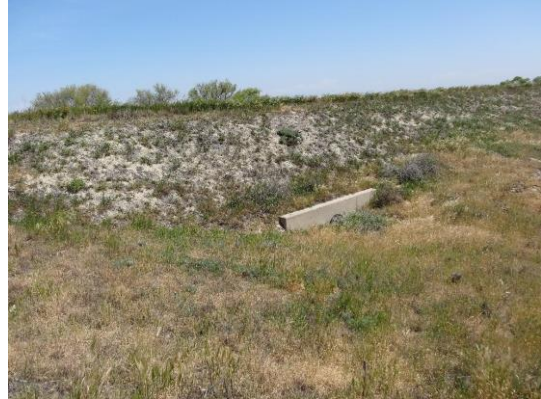
Photo 1 of 3 : UCIP_FA_2015_5234.jpg

View of landward side.

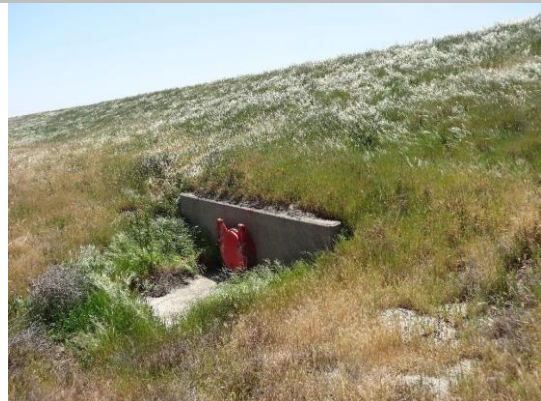
Photo 2 of 3 : UCIP_FA_2015_5235.jpg

Flap gate, concrete headwall and apron visible on waterward toe.

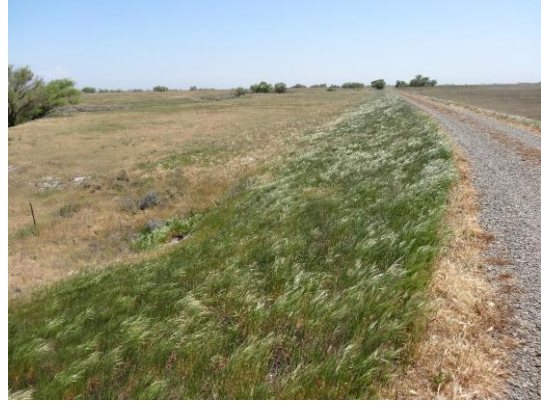
Photo 3 of 3 : UCIP_FA_2015_5236.jpg

View of waterward side.

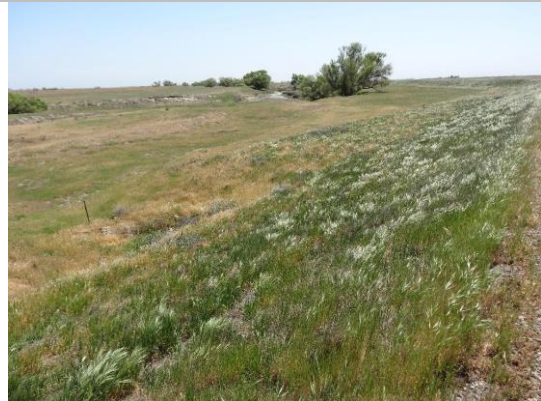
Photo 1 of 3 : UCIP_FA_2015_5272.jpg

View of waterward side.

Inspector Comments: FS_ID:36610
 DS_ID:19862
 EP_NO: N/A
 FS_HLM: 4.931
 Repair Type: Non-Urgent
 Crossing Status: Found
 UCIP Comments: Dense vegetation limits the inspector's visibility to identify signs of pipe failure (leaks) along the waterward slope. Recommend removing vegetation along waterward slope to conduct proper inspection of structure. Also recommend removing dense vegetation blocking landward headwall.
 FIELD_STRUCT_DESC: 24-inch CM pipe through levee, 10.8 feet below crown. Flap gate on the waterward end. Concrete headwall on both ends. (USACE-1967). This entry matches the Drainage or Irrigation Structure referenced in O&M manual (HLM 4.94).
 FS Date: 04/18/2014

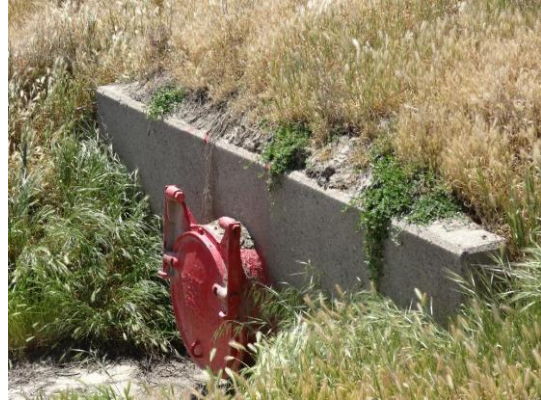
Photo 2 of 3 : UCIP_FA_2015_5273.jpg

Close up of flap gate located on waterward side.

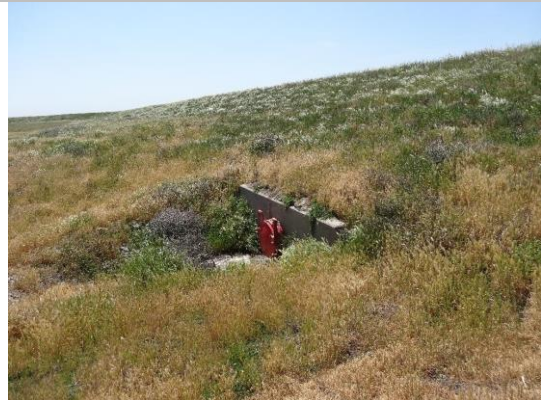
Photo 3 of 3 : UCIP_FA_2015_5274.jpg

View of flap gate, concrete headwall and apron located on waterward side.

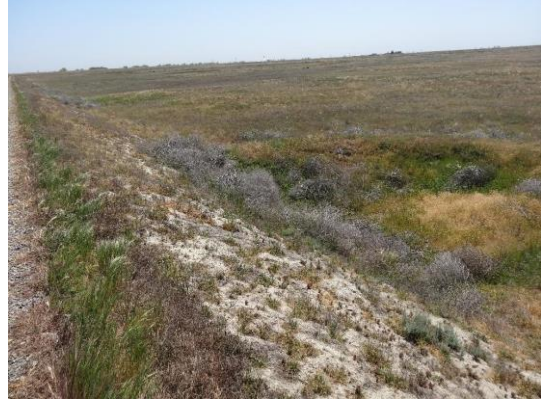
Photo 1 of 3 : UCIP_FA_2015_5444.jpg

View of landward side.

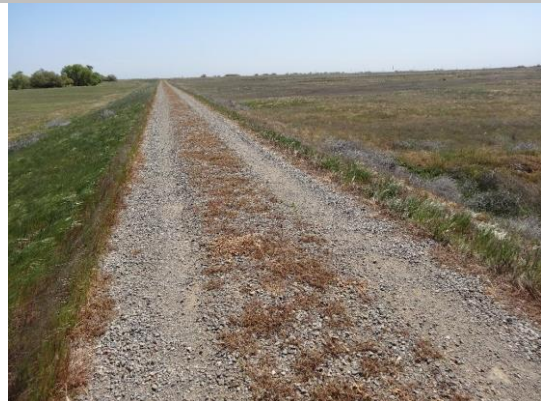
Photo 2 of 3 : UCIP_FA_2015_5445.jpg

Overview of levee crown at crossing.

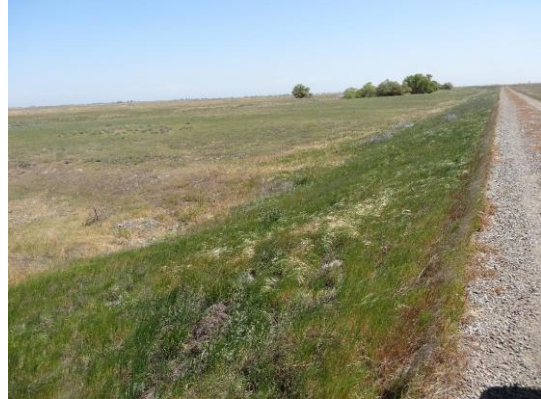
Photo 3 of 3 : UCIP_FA_2015_5446.jpg

View of waterward side.

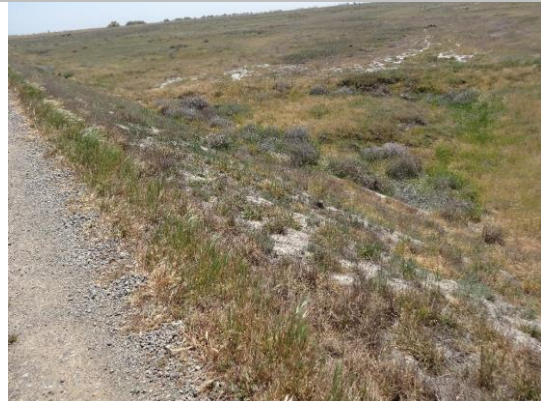
Photo 1 of 3 : UCIP_FA_2015_5275.jpg

View of landward side.

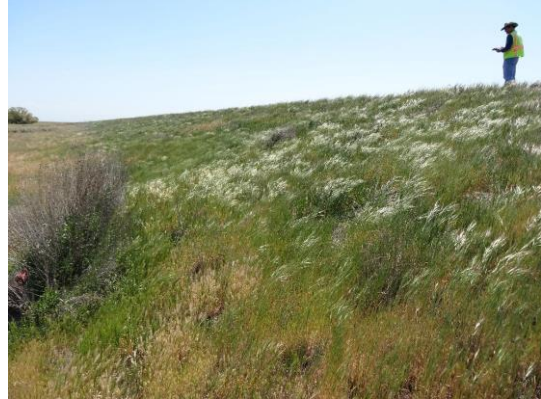
Photo 2 of 3 : UCIP_FA_2015_5276.jpg

View of waterward side--dense vegetation covers slope.

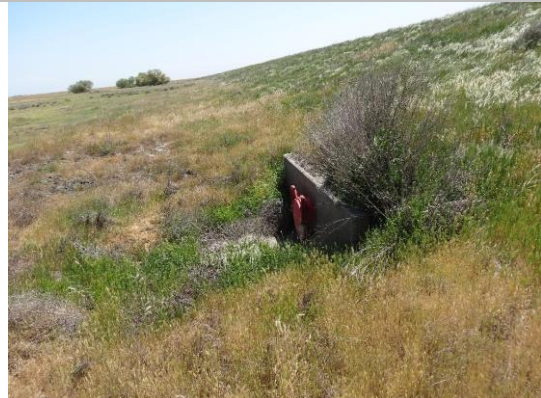
Photo 3 of 3 : UCIP_FA_2015_5277.jpg

Concrete headwall and flap gate visible on waterward toe.

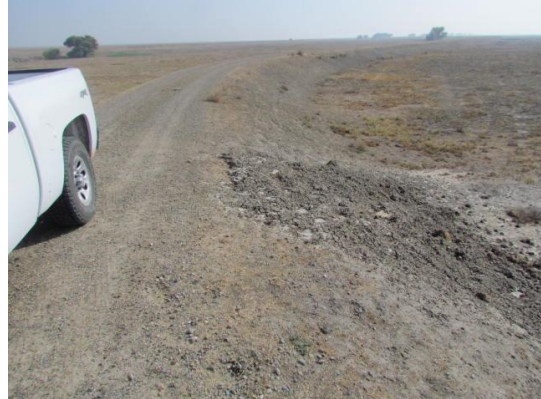
Photo 1 of 2 : FA_2015_NA0010_124_9_20150914_00011.jpg

LM Start	5.76	Rating **	A/W	Issue No.	9
LM End	5.76	Issue Type +	Ma	Location *	LS
Category	Earthen Levee			GPS Latitude/Longitude	
				Start	End
Item	Slope Stability			37.238355 °	37.238355 °
				-120.742677 °	-120.742677 °
DWR ID	DWR_NA0010_06_s _ 2012_9				
Action/Comments					
Repair the levee slope damaged by vehicle traffic and prevent access where possible.					
Inspector Comments: Levee damage caused by motorcylce traffic.

Looking northwest at damaged slope repaired on landward slope.

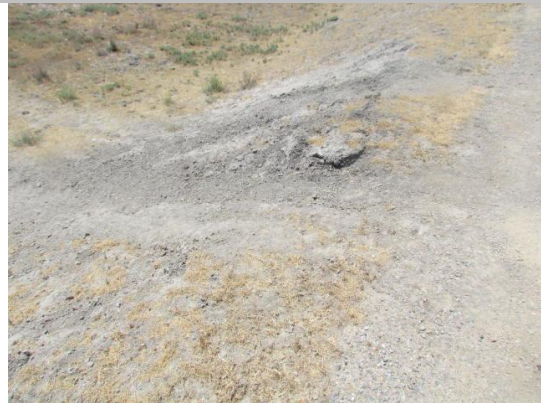
Photo 2 of 2 : FA_2015_NA0010_124_9_20150914_00012.jpg

Looking at slope damage caused by vehicle traffic on landward slope.

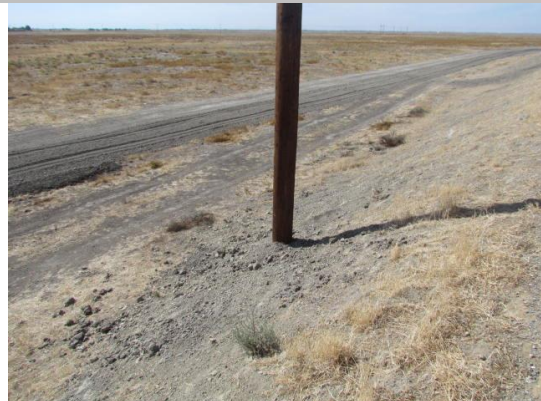
Photo 1 of 1 : FA_2015_NA0010_124_69_20151013_00034.jpg

LM Start	5.93	Rating **	U	Issue No.	69
LM End	6.25	Issue Type +	En	Location *	LS
Category	Earthen Levee			GPS Latitude/Longitude	
				Start	End
Item	Encroachments			37.236936 °	37.235487 °
				-120.740384 °	-120.737685 °
DWR ID	DWR_NA0010_06_f _ 2015_69				
Action/Comments					
Pole					
Inspector Comments: Several PG& E poles within this section at the landward toe and slope.

Looking at power pole on landward slope.

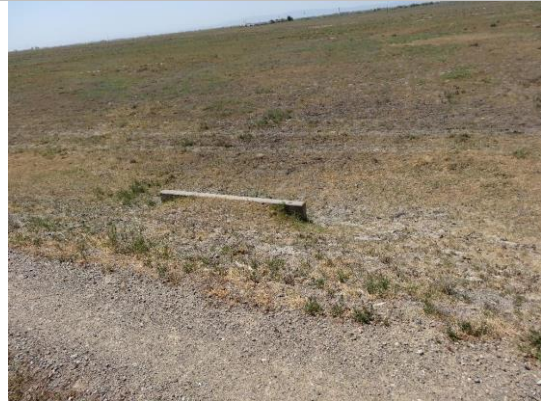
Photo 1 of 3 : UCIP_FA_2015_5447.jpg

Action/Comments					
Inspector Comments: FS_ID:39470 DS_ID:19865 EP_NO: N/A FS_HLM: 6.051 Repair Type: Non-Urgent Crossing Status: Found UCIP Comments: Need to contact owner. Sediment buildup in pipe visible on landward side--recommend clearing. FIELD_STRUCT_DESC: 24-inch CM pipe through levee, 9.0 feet below crown. Flap gate on the waterward end. Concrete headwall on both ends. (USACE-1967). This entry matches the Drainage or Irrigation Structure referenced in O&M manual (HLM 6.06). FS Date: 04/18/2014

View of landward side.

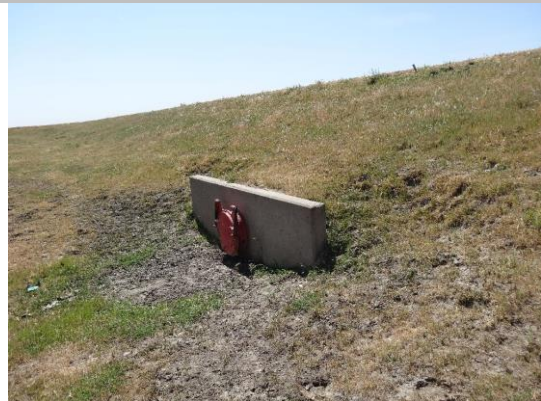
Photo 2 of 3 : UCIP_FA_2015_5448.jpg

View of waterward slope--flap gate appears operable.

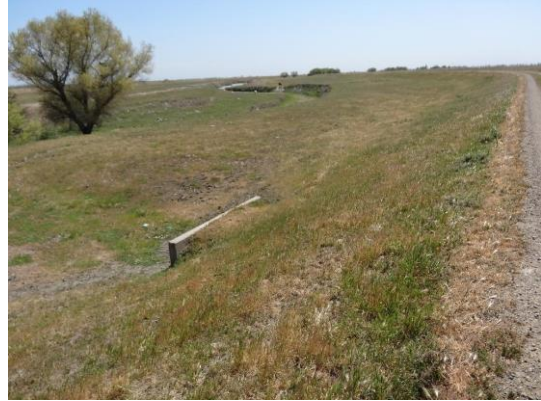
Photo 3 of 3 : UCIP_FA_2015_5449.jpg

View of waterward side.

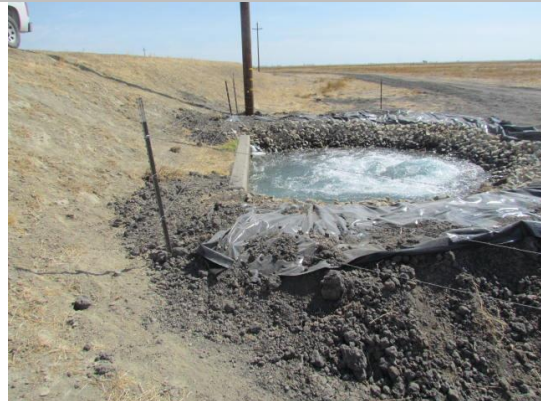
Photo 1 of 5 : FA_2015_NA0010_124_70_20151013_00035.jpg

LM Start	5.98	Rating **	U	Issue No.	70
LM End	5.98	Issue Type +	En	Location *	LS
Category	Earthen Levee			GPS Latitude/Longitude	
				Start	End
Item	Encroachments			37.236382 °	37.236382
				-120.739709 °	-120.739709
DWR ID	DWR_NA0010_06_f_2015_70				
Action/Comments					
Pipe					
Inspector Comments: Pipe from well at 15ft line with dyke around pipe to close to landward toe.

Looking south at dyke connected to drainage structure at landward toe.

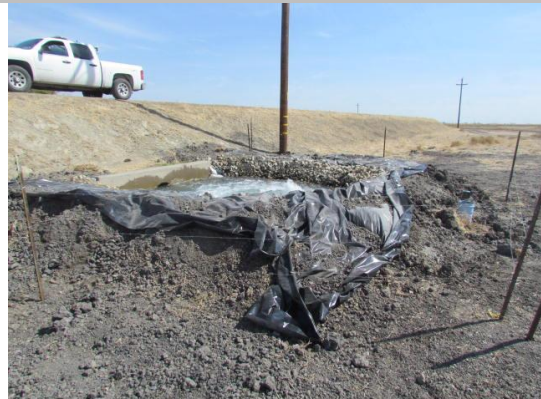
Photo 2 of 5 : FA_2015_NA0010_124_70_20151013_00036.jpg

Looking southwest at dyke connected to drainage structure at landward toe.

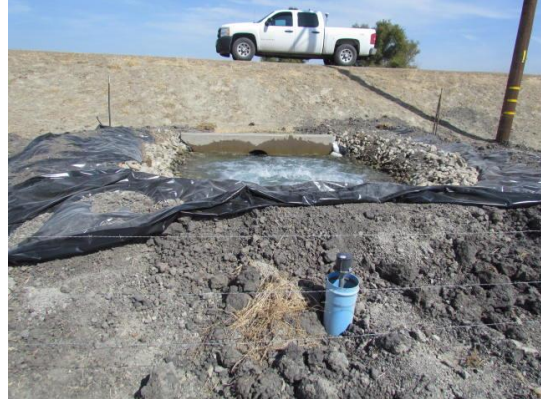
Photo 3 of 5 : FA_2015_NA0010_124_70_20151013_00037.jpg

Looking west at dyke connected to drainage structure at landward toe.

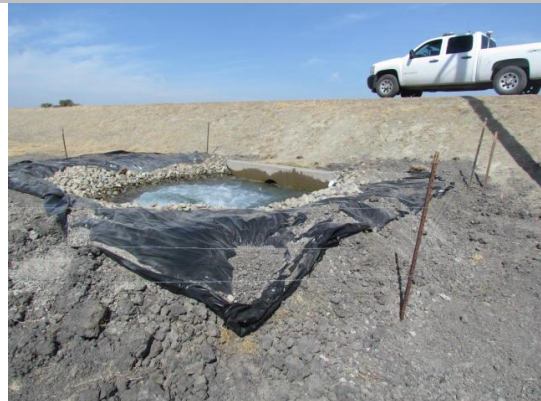
Photo 4 of 5 : FA_2015_NA0010_124_70_20151013_00038.jpg

Looking northwest at dyke connected to drainage structure at landward toe.

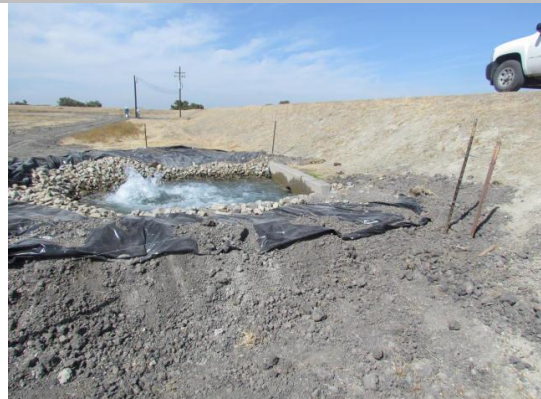
Photo 5 of 5 : FA_2015_NA0010_124_70_20151013_00039.jpg

Looking north at dyke connected to drainage structure at landward toe.

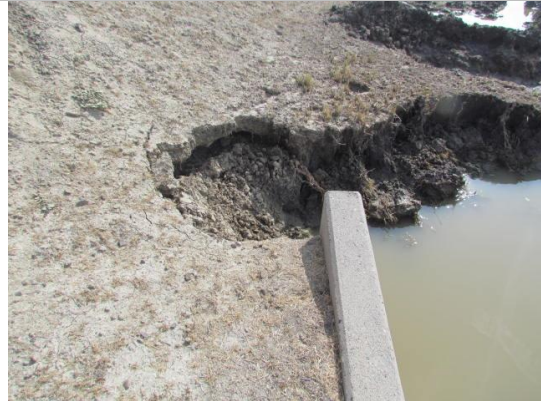
Photo 1 of 2 : FA_2015_NA0010_124_65_20150914_00018.jpg

LM Start	5.98	Rating **	U	Issue No.	65
LM End	5.98	Issue Type +	Ma	Location *	LS
Category	Interior Drainage & Piping Systems			GPS Latitude/Longitude	
				Start	End
Item	Erosion Areas			37.236372 °	37.236372 °
				-120.739706 °	-120.739706 °
DWR ID	DWR_NA0010_06_f_2014_65				
Action/Comments					
Inspector Comments: Erosion on right side of headwall at landward toe.

Looking northwest at erosion around headwall of drainage structure on landward toe.

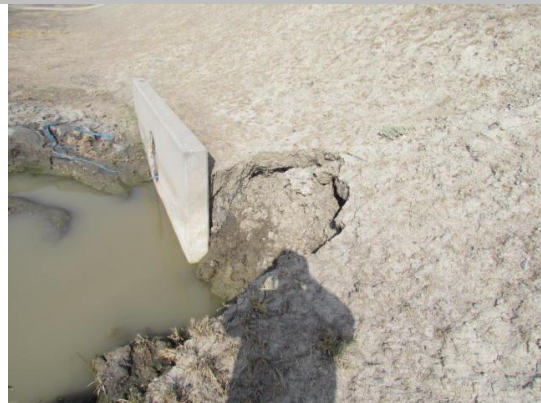
Photo 2 of 2 : FA_2015_NA0010_124_65_20150914_00019.jpg

Looking south erosion around headwall of drainage structure on landward toe.

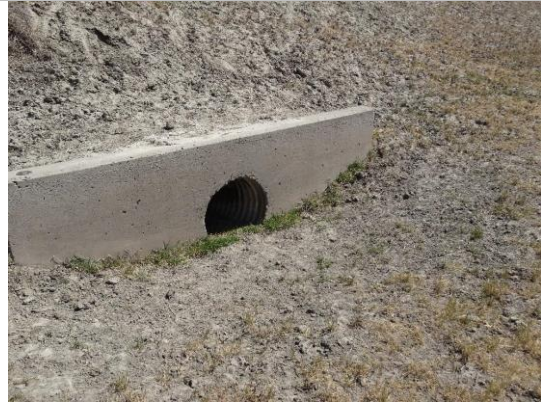
Photo 1 of 3 : UCIP_FA_2015_5596.jpg

Inspector Comments: FS_ID:39471
 DS_ID:19868
 EP_NO: N/A
 FS_HLM: 7.279
 Repair Type: Non-Urgent
 Crossing Status: Found
 UCIP Comments: Need to contact owner. Clear animal from waterward side. Some sediment buildup in pipe visible landward side--recommend clearing.
 FIELD_STRUCT_DESC: 24-inch CM pipe through levee, 10.6 feet below crown. Flap gate on the waterward end. Concrete headwall on both ends. (USACE-1967). This entry matches the Drainage or Irrigation Structure referenced in O&M manual (HLM 7.29).
 FS Date: 04/18/2014

View of landward side.

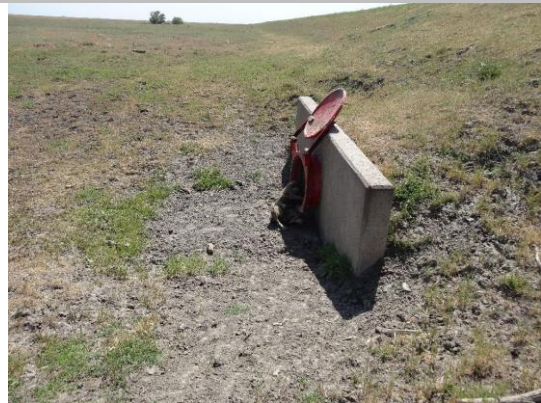
Photo 2 of 3 : UCIP_FA_2015_5597.jpg

Concrete headwall and flap gate visible on waterward side. Dead animal inside pipe.

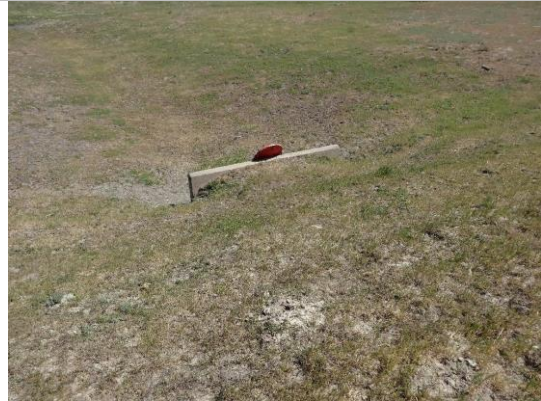
Photo 3 of 3 : UCIP_FA_2015_5598.jpg

View of waterward side.

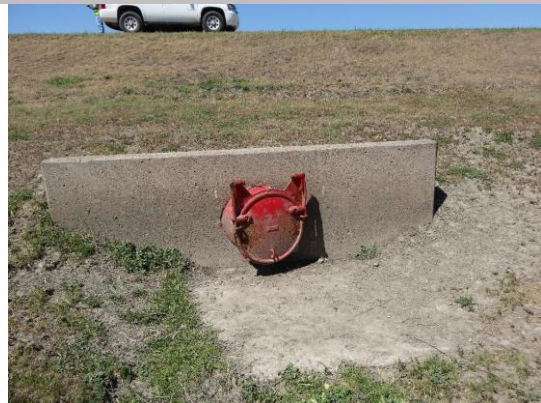
Photo 1 of 3 : UCIP_FA_2015_5278.jpg

LM Start	7.66	Rating **	M	Issue No.	1235
LM End	7.66	Issue Type +	En	Location *	LS
Category	Supplemental			GPS Latitude/Longitude	
				Start	End
Item	DWR UCIP Field Study			37.222743 °	37.222743 °
				-120.716416 °	-120.716416 °
DWR ID					
Action/Comments					
Inspector Comments: FS_ID:39472					
DS_ID:19869					
EP_NO: N/A					
FS_HLM: 7.729					
Repair Type: Non-Urgent					
Crossing Status: Found					
UCIP Comments: Some sediment buildup in pipe visible on landward side--recommend clearing.					
FIELD_STRUCT_DESC: 24-inch CM pipe through levee, 11.8 feet below crown. Flap gate on the waterward end. Concrete headwall on both ends. (USACE-1967). This entry matches the Drainage or Irrigation Structure referenced in O&M manual (HLM 7.74). Skewed crossing					
FS Date: 04/18/2014

Concrete headwall and flap gate visible on waterward side.

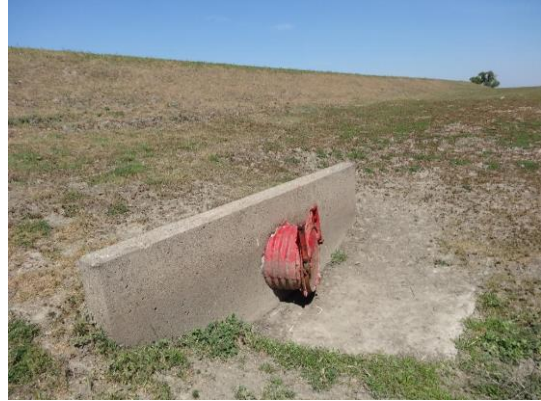
Photo 2 of 3 : UCIP_FA_2015_5279.jpg

Inspector Comments: FS_ID:39472
 DS_ID:19869
 EP_NO: N/A
 FS_HLM: 7.729
 Repair Type: Non-Urgent
 Crossing Status: Found
 UCIP Comments: Some sediment buildup in pipe visible on landward side--recommend clearing.
 FIELD_STRUCT_DESC: 24-inch CM pipe through levee, 11.8 feet below crown. Flap gate on the waterward end. Concrete headwall on both ends. (USACE-1967). This entry matches the Drainage or Irrigation Structure referenced in O&M manual (HLM 7.74). Skewed crossing
 FS Date: 04/18/2014

Pipe crosses levee at an angle.

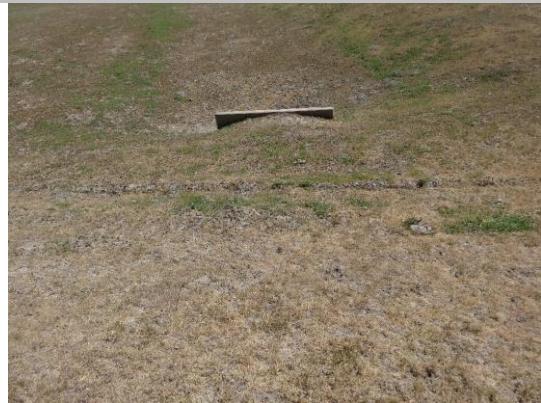
Photo 3 of 3 : UCIP_FA_2015_5280.jpg

View of waterward side.

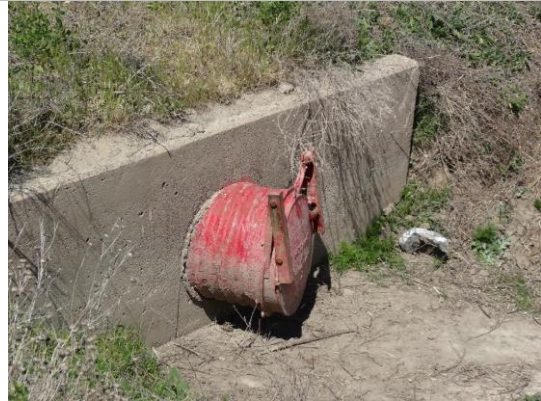
Photo 1 of 3 : UCIP_FA_2015_5697.jpg

Concrete headwall and flap gate visible on waterward side.

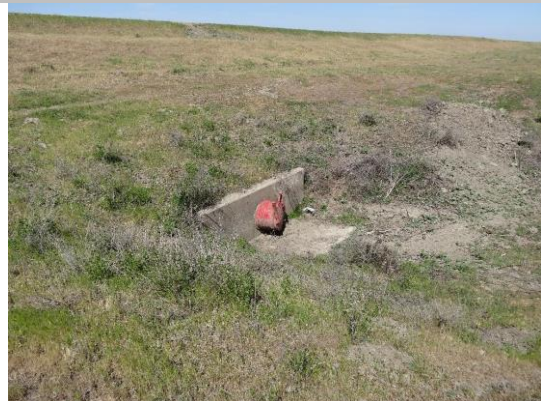
Photo 2 of 3 : UCIP_FA_2015_5698.jpg

Pipe crosses levee at an angle.

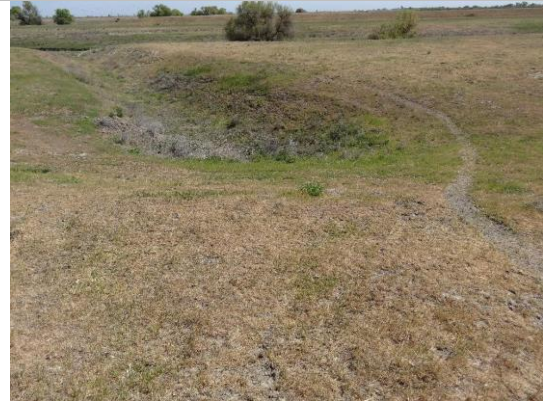
Photo 3 of 3 : UCIP_FA_2015_5699.jpg

View of waterward side.

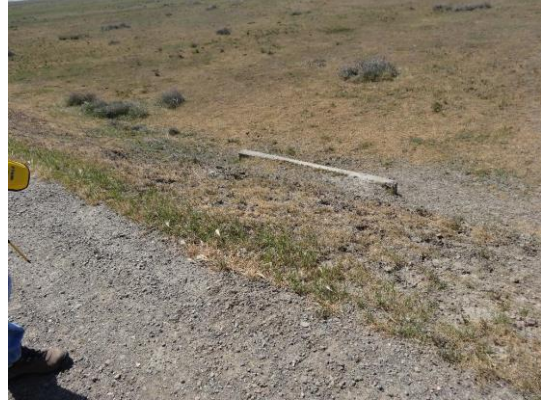
Photo 2 of 3 : UCIP_FA_2015_5701.jpg

View of landward side.

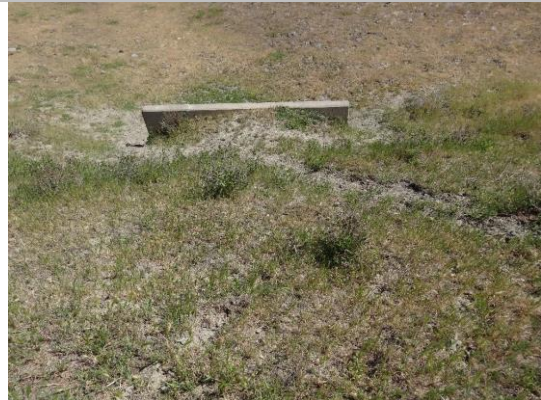
Photo 3 of 3 : UCIP_FA_2015_5702.jpg

View of waterward side.

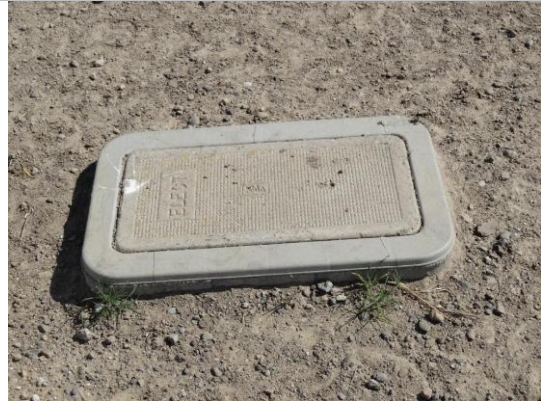
Photo 1 of 2 : UCIP_FA_2015_6719.jpg

Service box is for electrical conduit.

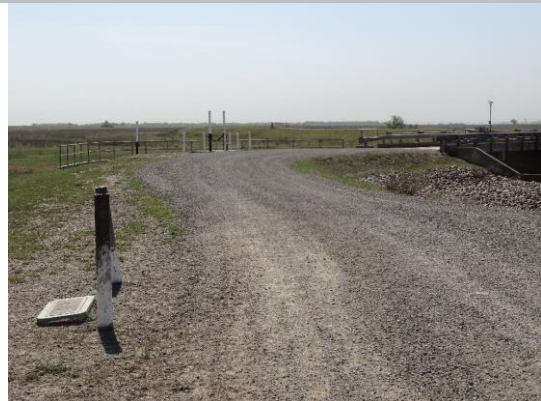
Photo 2 of 2 : UCIP_FA_2015_6720.jpg

Service box located on waterward levee shoulder.

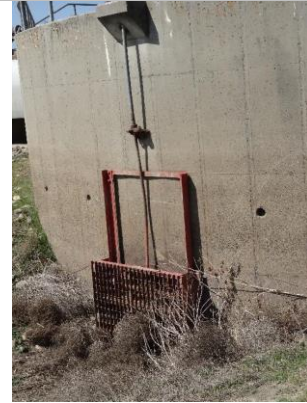
Photo 1 of 3 : UCIP_FA_2015_6690.jpg

Trash gate visible on waterward side.

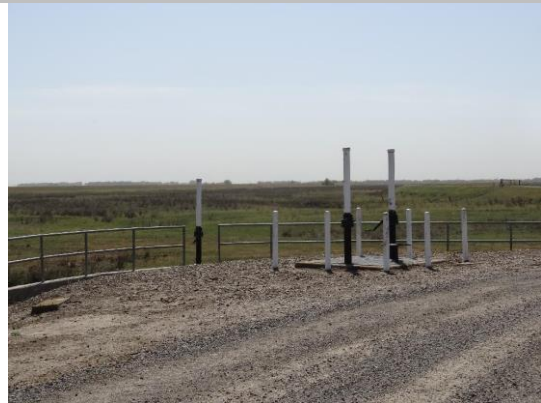
Photo 2 of 3 : UCIP_FA_2015_6691.jpg

Concrete box located on waterward side.

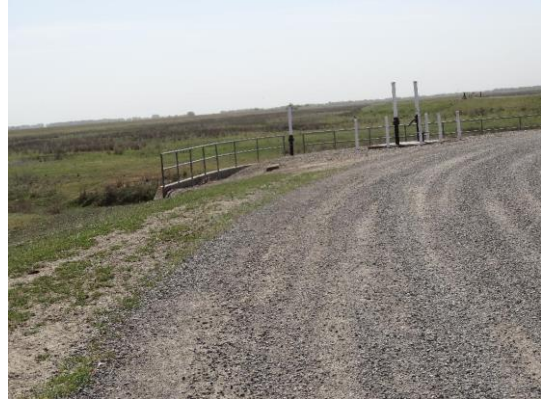
Photo 3 of 3 : UCIP_FA_2015_6692.jpg

Overview of levee crown looking upstream.

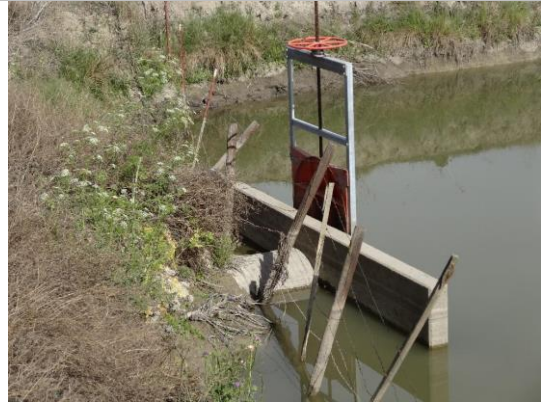
Photo 1 of 2 : UCIP_FA_2015_5703.jpg

LM Start	9.66	Rating **	M	Issue No.	1245
LM End	9.66	Issue Type +	En	Location *	LS
Category	Supplemental			GPS Latitude/Longitude	
				Start	End
Item	DWR UCIP Field Study			37.200948 °	37.200948 °
				-120.694362 °	-120.694362 °
DWR ID					
Action/Comments					
Inspector Comments: FS_ID:39475					
DS_ID:19874					
EP_NO: N/A					
FS_HLM: 9.735					
Repair Type: Non-Urgent					
Crossing Status: Found					
UCIP Comments: Waterward side not visible--need to determine alignment.					
FIELD_STRUCT_DESC: 36-inch CM pipe through levee, 14.0 feet below crown. Slide gate in concrete diversion box on the waterward shoulder.					
FS Date: 04/17/2014

Pipe, slide gate, and concrete headwall visible on landward side.

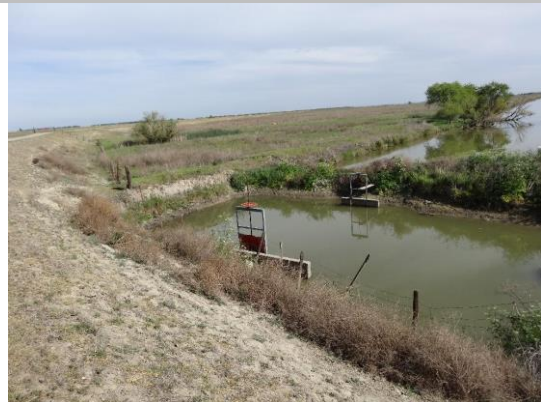
Photo 2 of 2 : UCIP_FA_2015_5704.jpg

View of landward side.

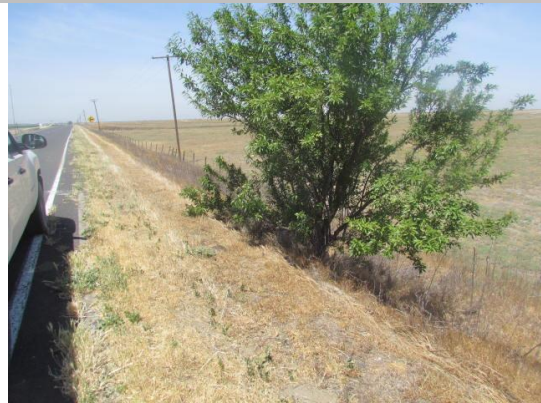
Photo 1 of 1 : FA_2015_NA0010_124_14_20150914_00015.jpg

LM Start	11.49	Rating **	M	Issue No.	14
LM End	11.49	Issue Type +	Ma	Location *	WS
Category	Earthen Levee			GPS Latitude/Longitude	
				Start	End
Item	Trim / Thin Trees			37.186189 °	37.186189
				-120.668476 °	-120.668476
DWR ID	DWR_NA0010_06_s _ 2015_14				
Action/Comments					
Trim trees to at least five feet above ground level. Inspector Comments: Almond tree located along Sandy Mush Rd. on waterward slope.

Looking west at tree on waterward slope.

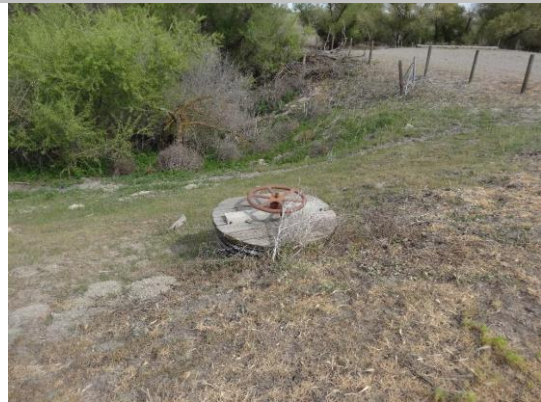
Photo 1 of 3 : UCIP_FA_2015_4778.jpg

Action/Comments					
Inspector Comments: FS_ID:39476 DS_ID:19876 EP_NO: N/A FS_HLM: 11.821 Repair Type: Non-Urgent Crossing Status: Found UCIP Comments: Clear debris from waterward and landward toes. FIELD_STRUCT_DESC: 36-inch CM pipe through levee, 17.0 feet below crown. Slide gate in pipe riser on the waterward slope. (USACE-1967). This entry matches the Drainage or Irrigation Structure referenced in O&M manual (HLM 11.82). FS Date: 04/17/2014

Slide gate inside CMP riser located on waterward slope.

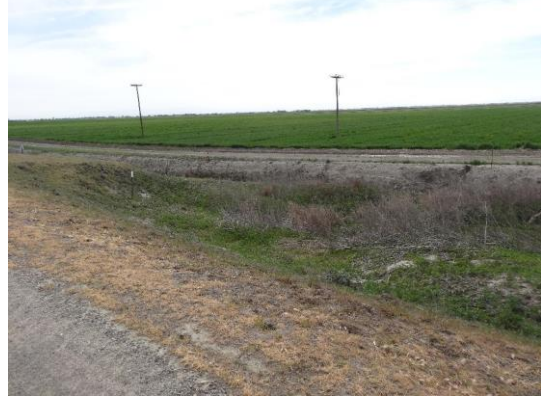
Photo 2 of 3 : UCIP_FA_2015_4779.jpg

View of landward side.

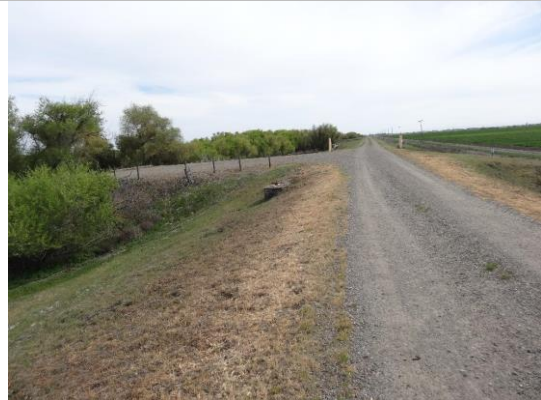
Photo 3 of 3 : UCIP_FA_2015_4780.jpg

View of waterward side.

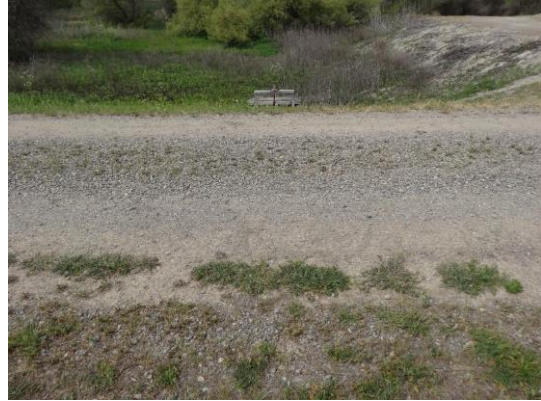
Photo 1 of 3 : UCIP_FA_2015_4781.jpg

View of levee crown at crossing.

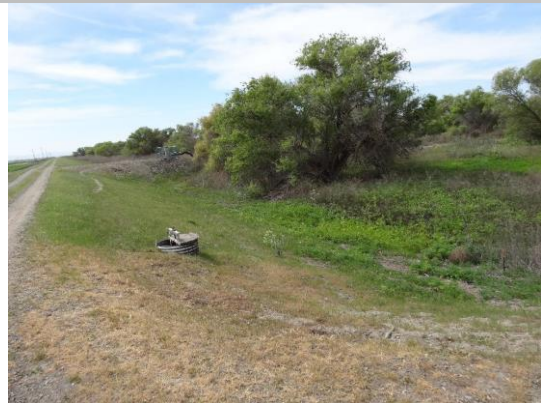
Photo 2 of 3 : UCIP_FA_2015_4782.jpg

View of waterward slope.

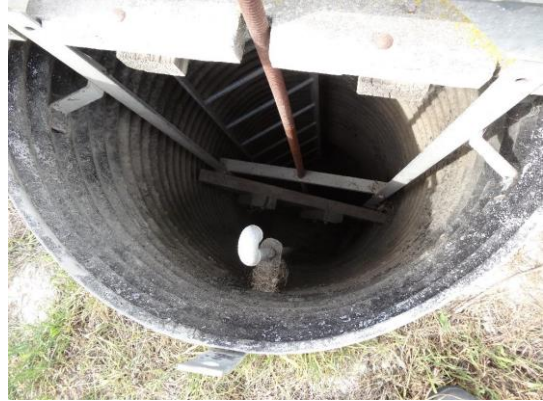
Photo 3 of 3 : UCIP_FA_2015_4783.jpg

Inside view of CMP riser located on waterward slope.

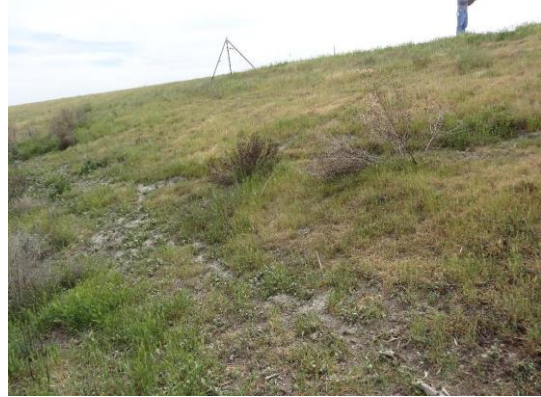
Photo 1 of 3 : UCIP_FA_2015_4784.jpg

Action/Comments					
Inspector Comments: FS_ID:39478 DS_ID:19878 EP_NO: N/A FS_HLM: 14.45 Repair Type: Non-Urgent Crossing Status: Found UCIP Comments: Not accessible--crossing is buried on landward side. Need to contact owner to determine status. FIELD_STRUCT_DESC: 24-inch CM pipe through levee, 12.3 feet below crown. Flap gate on the waterward end. (USACE-1967). This entry matches the Drainage or Irrigation Structure referenced in O&M manual (HLM 14.44). FS Date: 04/17/2014

View of waterward slope.

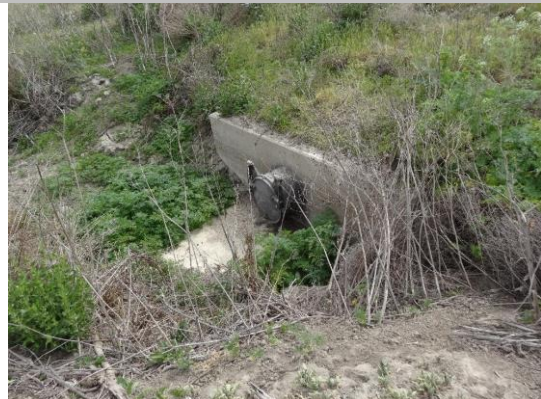
Photo 2 of 3 : UCIP_FA_2015_4785.jpg

View of pipe daylight, flap gate, and concrete headwall visible on waterward toe.

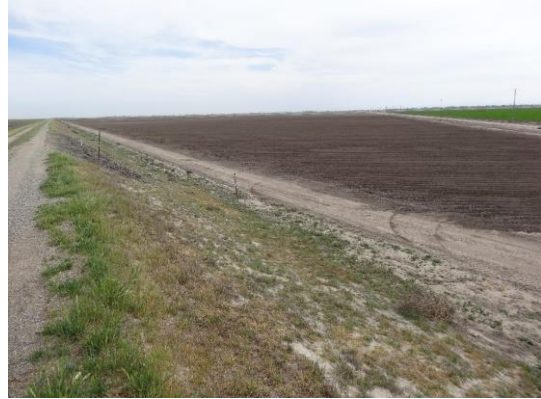
Photo 3 of 3 : UCIP_FA_2015_4786.jpg

View of landward slope.

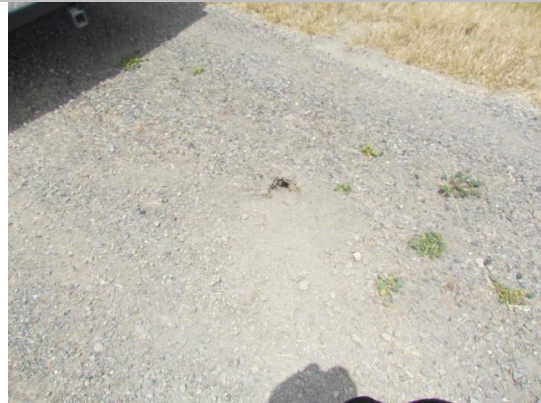
Photo 1 of 1 : FA_2015_NA0010_124_1212_20150914_00030.jpg

LM Start	14.94	Rating **	M	Issue No.	1212
LM End	14.94	Issue Type +	Ma	Location *	CR
Category	Earthen Levee			GPS Latitude/Longitude	
				Start	End
Item	Animal Control			37.162287 °	37.162287 °
				-120.628791 °	-120.628791 °
DWR ID	DWR_NA0010_06_s_2015_1212				
Action/Comments					
No rodents visible, but rodent burrows visible; need to backfill and compact or grout burrows. Inspector Comments: Several rodent holes noted on levee crown and landside and waterside slopes.

Looking at rodent hole on levee crown.

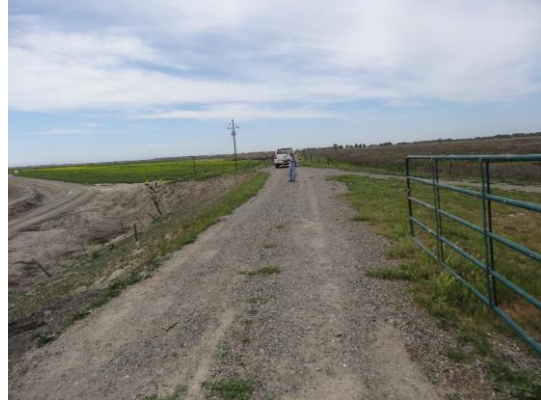
Photo 1 of 3 : UCIP_FA_2015_4787.jpg

Inspector Comments: FS_ID:39480
 DS_ID:19884
 EP_NO: N/A
 FS_HLM: 15.766
 Repair Type: Non-Urgent
 Crossing Status: Found
 UCIP Comments: Need to contact owner. Sediment buildup on both the waterward and landward side. Recommend removing sediment buildup from both side. Also recommend clearing excess sediment inside crossing.
 FIELD_STRUCT_DESC: 24-inch CM pipe through levee, 14.0 feet below crown. Flap gate on the waterward end. (USACE-1967). This entry matches the Drainage or Irrigation Structure referenced in O&M manual (HLM 15.76).
 FS Date: 04/17/2014

Overview of levee crown at crossing.

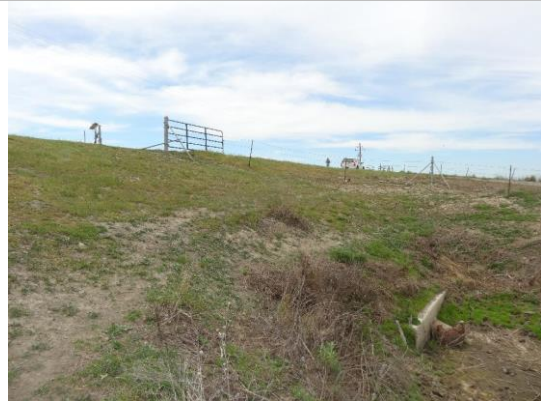
Photo 2 of 3 : UCIP_FA_2015_4808.jpg

View of waterward side.

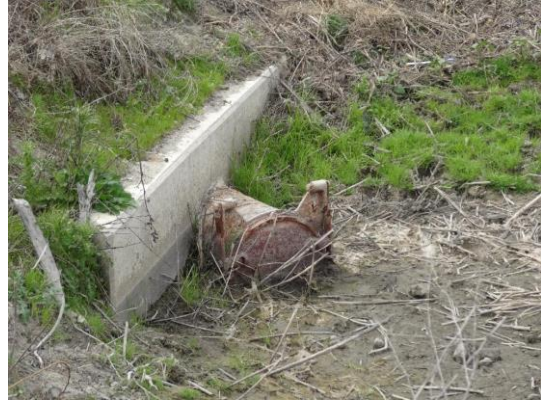
Photo 3 of 3 : UCIP_FA_2015_4809.jpg

Flap gate buried halfway on waterward side.

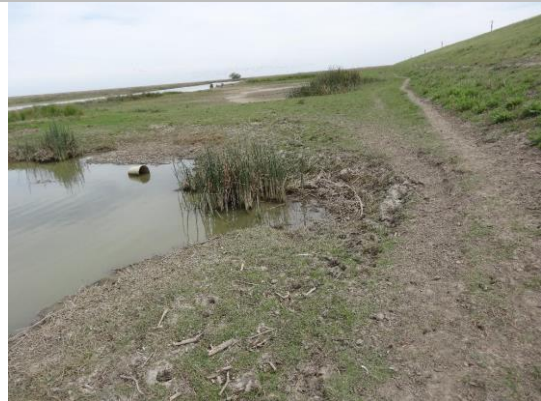
Photo 1 of 3 : UCIP_FA_2015_4810.jpg

LM Start	15.82	Rating **	M	Issue No.	1251
LM End	15.82	Issue Type +	En	Location *	LS
Category	Supplemental			GPS Latitude/Longitude	
				Start	End
Item	DWR UCIP Field Study			37.155539 °	37.155539 °
				-120.615303 °	-120.615303 °
DWR ID					
Action/Comments					
Inspector Comments: FS_ID:36663 DS_ID:19885 EP_NO: N/A FS_HLM: 15.913 Repair Type: Non-Urgent Crossing Status: Found UCIP Comments: Need to contact owner to determine status of crossing. Waterward side is buried and not accessible. Landward side headwall is blocked by dense vegetation. Recommend confirming status of flap gate on waterward side and removing dense vegetation form landward side. FIELD_STRUCT_DESC: 36-inch CM pipe through levee, 16.6 feet below crown. Flap gate on the waterward end. (USACE-1967). This entry matches the Drainage or Irrigation Structure referenced in O&M manual (HLM 15.91). FS Date: 04/17/2014

View of waterward side, photo 2 of 3.

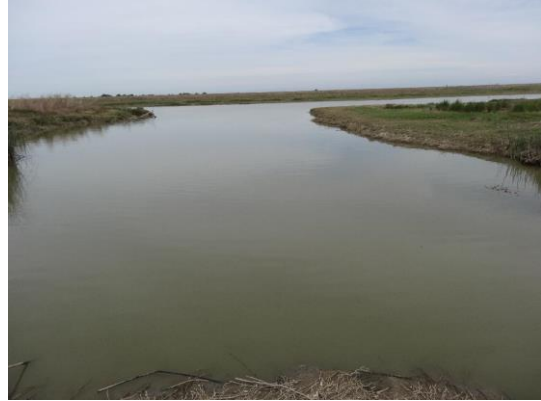
Photo 2 of 3 : UCIP_FA_2015_4811.jpg

View of waterward side, photo 3 of 3.

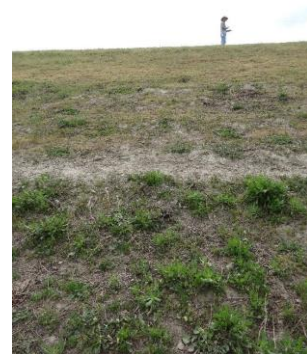
Photo 3 of 3 : UCIP_FA_2015_4927.jpg

View of waterward side, Photo 1 of 3.

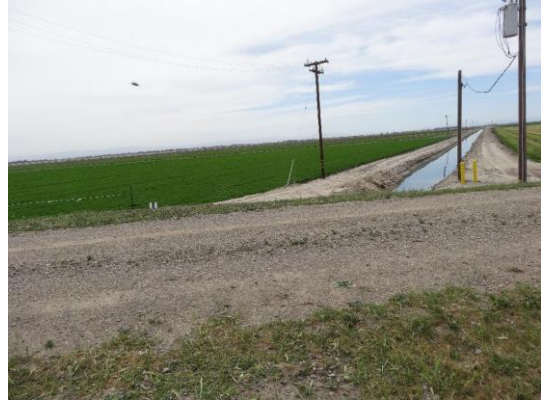
Photo 1 of 3 : UCIP_FA_2015_3136.jpg

LM Start	16.40	Rating **	M	Issue No.	1252
LM End	16.40	Issue Type +	En	Location *	LS
Category	Supplemental			GPS Latitude/Longitude	
				Start	End
Item	DWR UCIP Field Study			37.149747 °	37.149747 °
				-120.607702 °	-120.607702 °
DWR ID					
Action/Comments					
Inspector Comments: FS_ID:36665					
DS_ID:19559					
EP_NO: N/A					
FS_HLM: 16.477					
Repair Type: Non-Urgent					
Crossing Status: Found

View of landward side, photo 1 of 2.

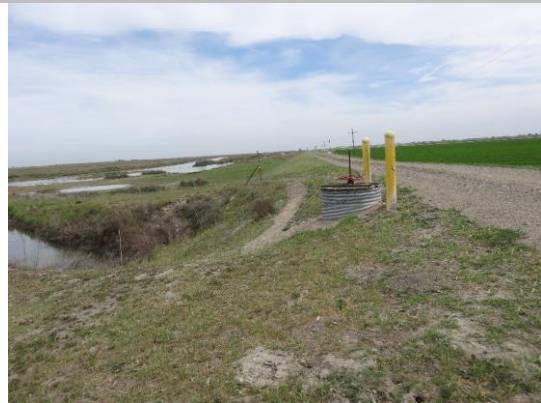
Photo 2 of 3 : UCIP_FA_2015_3137.jpg

View of waterward side.

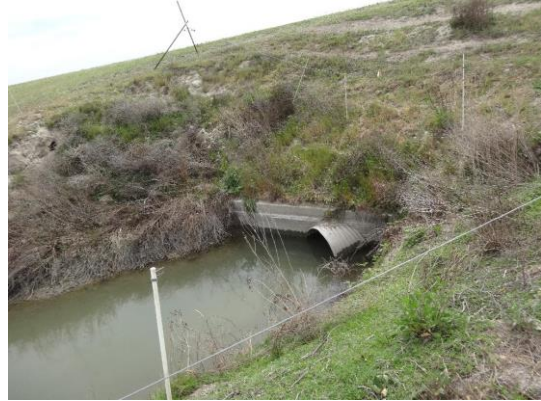
Photo 3 of 3 : UCIP_FA_2015_4928.jpg

Concrete headwall and pipe visible on waterward side.

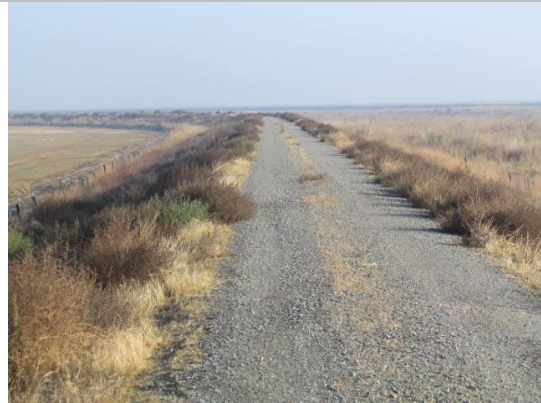
Photo 1 of 1 : FA_2015_NA0010_124_63_20150914_00016.jpg

LM Start	16.89	Rating **	M	Issue No.	63
LM End	19.22	Issue Type +	Ma	Location *	LS
Category	Earthen Levee			GPS Latitude/Longitude	
				Start	End
Item	Vegetation			37.144129 °	37.113644 °
				-120.602479 °	-120.588271 °
DWR ID	DWR_NA0010_06_f_2014_63				
Action/Comments					
Remove the wild growth other than native grasses from the levee slopes.					
Inspector Comments: Control tumble weeds on landward and waterward slopes.

Looking north at tumble weeds on levee slopes.

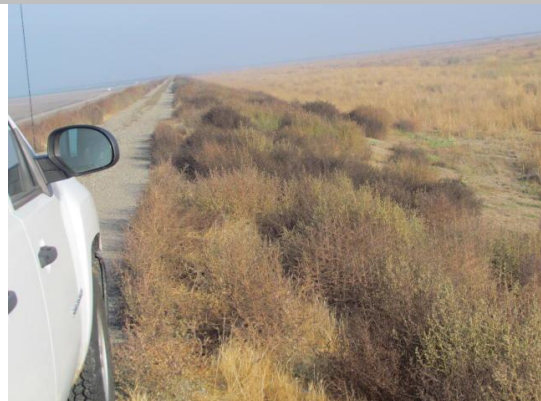
Photo 1 of 1 : FA_2015_NA0010_124_64_20150914_00017.jpg

LM Start	16.89	Rating **	M	Issue No.	64
LM End	18.79	Issue Type +	Ma	Location *	WS
Category	Earthen Levee			GPS Latitude/Longitude	
				Start	End
Item	Vegetation			37.144128 °	37.119569 °
				-120.602479 °	-120.587353 °
DWR ID	DWR_NA0010_06_f_2014_64				
Action/Comments					
Remove the wild growth other than native grasses from the levee slopes.					
Inspector Comments: Dense tumble weeds on waterward slope.

Looking northeast at dense tumble weeds on waterward slope.

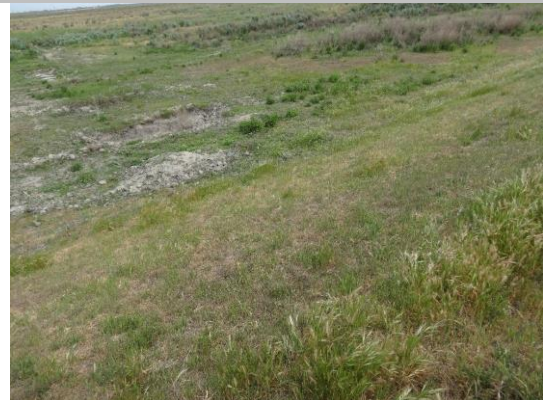
Photo 1 of 3 : UCIP_FA_2015_3724.jpg

Action/Comments					
Inspector Comments: FS_ID:42941 DS_ID:19888 EP_NO: 3040 FS_HLM: 18.91 Repair Type: Urgent Crossing Status: Found UCIP Comments: Need to contact owner. Leak on waterward toe approximately 15 feet from toe. Good candidate for video or pressure test. FIELD_STRUCT_DESC: 48-inch CM pipe through levee, 8.8 feet below crown. Slide gate in riser pipe on the landward side (not waterward slope). Concrete headwall on the landward side (not waterward side). Siphon under channel. 24-inch CM "clean out" pipe at center of channel, metal plate cover. (Permit No. 3040-1960) FS Date: 04/17/2014

View of waterward side. Channel section exposed near waterward toe.

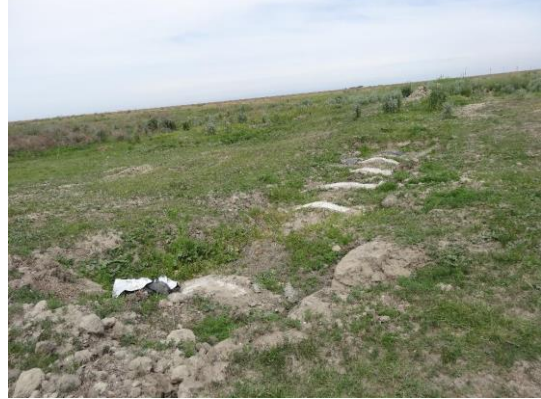
Photo 2 of 3 : UCIP_FA_2015_3725.jpg

Channel sections have been excavated across Eastside Bypass.

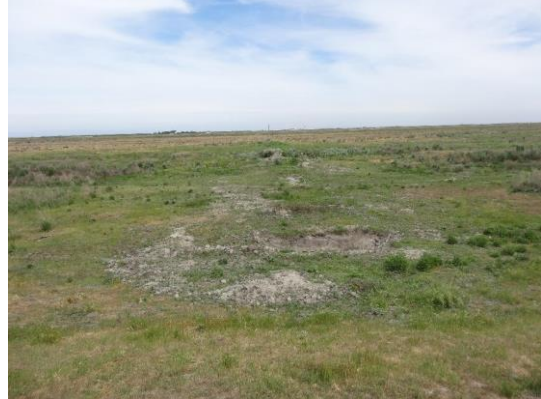
Photo 3 of 3 : UCIP_FA_2015_3726.jpg

Overview of Eastside Bypass.

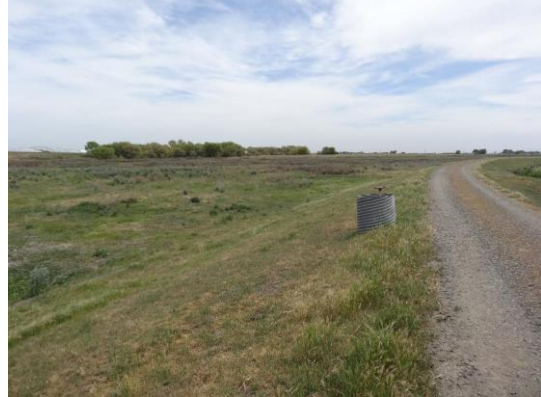
Photo 1 of 3 : UCIP_FA_2015_4344.jpg

LM Start	18.89	Rating **	M	Issue No.	1255
LM End	18.89	Issue Type +	En	Location *	WS
Category	Supplemental			GPS Latitude/Longitude	
				Start	End
Item	DWR UCIP Field Study			37.118178 °	37.118178 °
				-120.586783 °	-120.586783 °
DWR ID					
Action/Comments					
Inspector Comments: FS_ID:36687					
DS_ID:19889					
EP_NO: N/A					
FS_HLM: 18.98					
Repair Type: Non-Urgent					
Crossing Status: Found

View of waterward side.

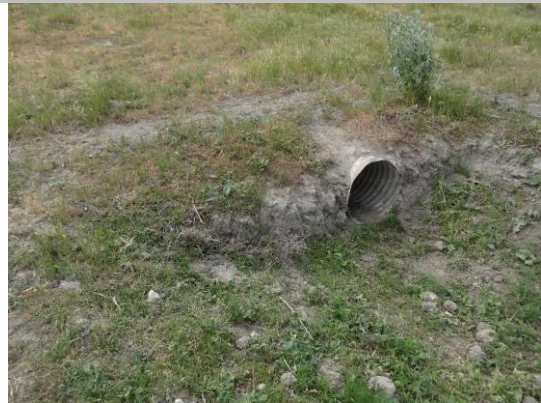
Photo 2 of 3 : UCIP_FA_2015_4345.jpg

Pipe daylight on waterward side.

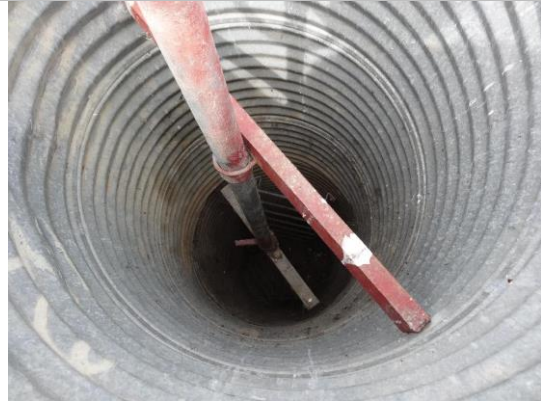
Photo 3 of 3 : UCIP_FA_2015_4346.jpg

Inside view of CMP riser located on waterward slope.

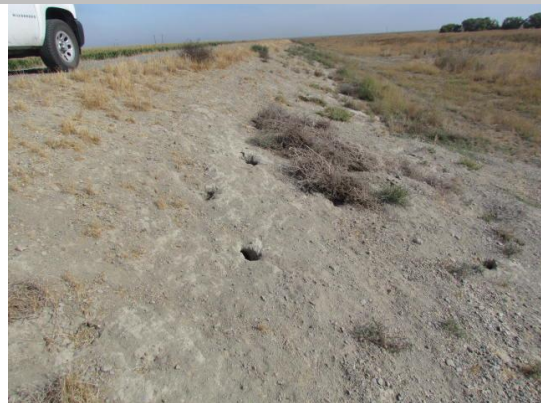
Photo 1 of 4 : FA_2015_NA0010_124_1211_20151013_00040.jpg

LM Start	19.14	Rating **	U	Issue No.	1211
LM End	19.14	Issue Type +	Ma	Location *	WS
Category	Earthen Levee			GPS Latitude/Longitude	
				Start	End
Item	Animal Control			37.114793 °	37.114793 °
				-120.587582 °	-120.587582 °
DWR ID	DWR_NA0010_06_s_2015_1211				
Action/Comments					
Exterminate rodents and backfill and compact or grout burrows. Inspector Comments: Several large rodent holes with more than 2 cubic feet of material was noted on waterward slope

Looking at several rodent holes on waterward slope. (Fall 2015)

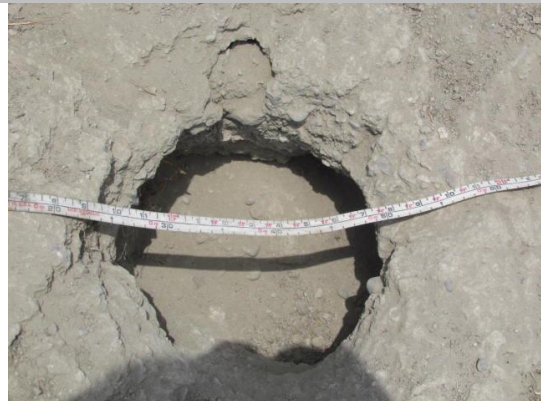
Photo 2 of 4 : FA_2015_NA0010_124_1211_20150914_00027.jpg

Looking at close-up view of large rodent hole on waterward slope.
(Spring 2015)

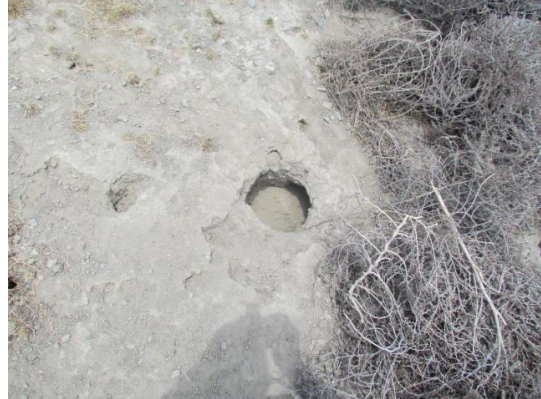
Photo 3 of 4 : FA_2015_NA0010_124_1211_20150914_00028.jpg

LM Start	19.14	Rating **	U	Issue No.	1211 (cont)
LM End	19.14	Issue Type +	Ma	Location *	WS
Category	Earthen Levee			GPS Latitude/Longitude	
				Start	End
Item	Animal Control			37.114793 °	37.114793 °
				-120.587582 °	-120.587582 °
DWR ID	DWR_NA0010_06_s_2015_1211				
Action/Comments					
Exterminate rodents and backfill and compact or grout burrows. Inspector Comments: Several large rodent holes with more than 2 cubic feet of material was noted on waterward slope

Looking at large rodent hole on waterward slope. Spring 2015

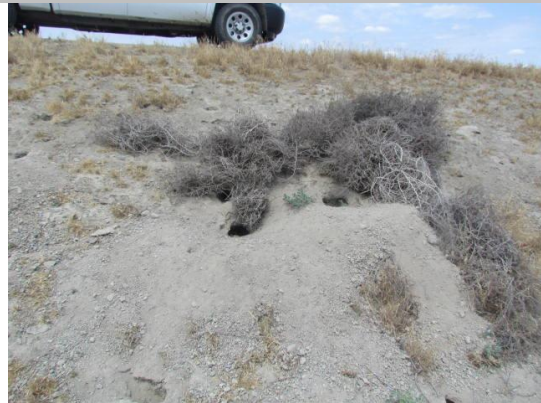
Photo 4 of 4 : FA_2015_NA0010_124_1211_20150914_00029.jpg

Looking west at several rodent holes on waterward slope. Spring 2015

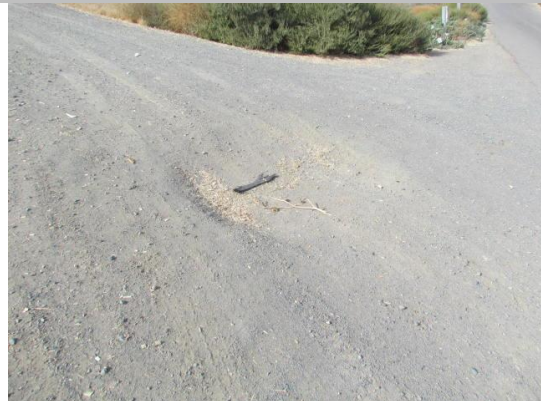
Photo 1 of 1 : FA_2015_NA0010_124_67_20151013_00041.jpg

LM Start	19.24	Rating **	U	Issue No.	67
LM End	19.24	Issue Type +	Ma	Location *	CR
Category	Earthen Levee			GPS Latitude/Longitude	
				Start	End
Item	Crown Surface / Depressions / Rutting			37.113397 °	37.113397 °
				-120.588441 °	-120.588441 °
DWR ID	DWR_NA0010_06_f_2015_67				
Action/Comments					
Repair depressions or ruts in the crown or slope.					
Inspector Comments: Large pot hole on levee crown.

Looking at large pot hole on levee crown.
