**Flood Control Project Maintenance
Levee Inspections**

Fall 2015 Levee Maintenance Deficiency Summary Report

San Joaquin River Basin

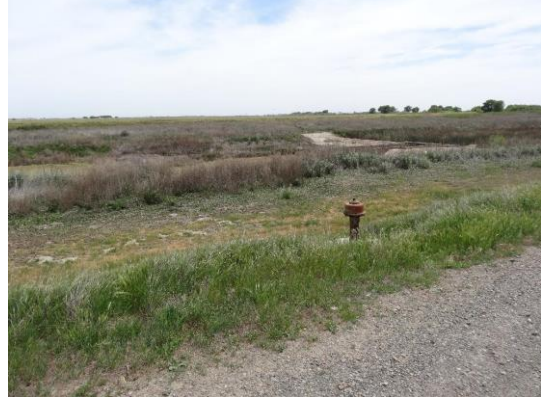
Photo 1 of 3 : UCIP_FA_2015_4347.jpg

Inspector Comments: FS_ID:36688
 DS_ID:19890
 EP_NO: N/A
 FS_HLM: 19.381
 Repair Type: Non-Urgent
 Crossing Status: Found
 UCIP Comments: Dense vegetation limits the inspector's visibility to identify signs of pipe failure (leaks) along the slopes. Recommend removing vegetation along pipe alignment to conduct proper inspection of structure.
 FIELD_STRUCT_DESC: 48-inch CM pipe through levee, 20.0 feet below crown. Slide gate in pipe riser on the waterward slope. (USACE-1967). This entry matches the Drainage or Irrigation Structure referenced in O&M manual (HLM 19.36). Rip rap along landward slope.
 FS Date: 04/17/2014

View of waterward side.

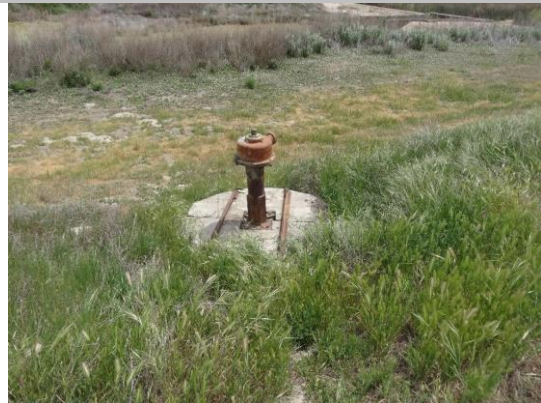
Photo 2 of 3 : UCIP_FA_2015_4348.jpg

Riser located on waterward slope.

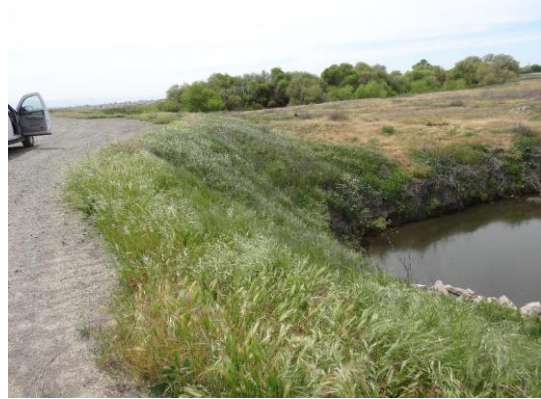
Photo 3 of 3 : UCIP_FA_2015_4349.jpg

View of landward slope.

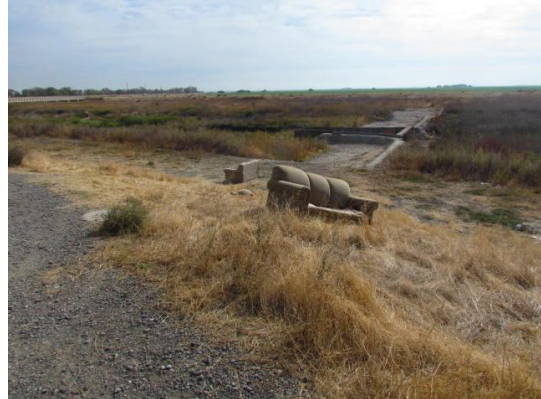
Photo 1 of 1 : FA_2015_NA0010_124_66_20151013_00042.jpg

LM Start	19.31	Rating **	M	Issue No.	66
LM End	19.31	Issue Type +	Ma	Location *	WS
Category	Earthen Levee			GPS Latitude/Longitude	
				Start	End
Item	Encroachments			37.112512 °	37.112512 °
				-120.589051 °	-120.589051 °
DWR ID	DWR_NA0010_06_f_2015_66				
Action/Comments					
Garbage					
Inspector Comments: Garbage (sofa) on waterward slope and berm.

Looking at garbage (sofa) on waterward slope.

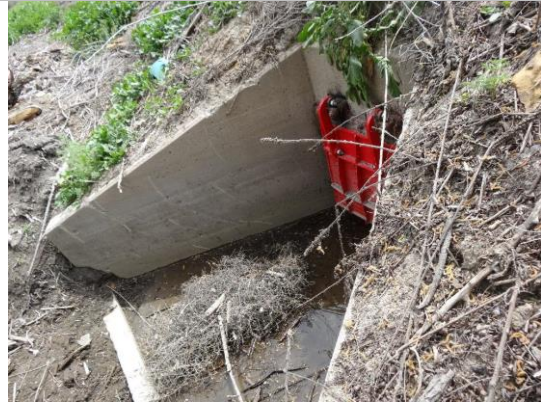
Photo 1 of 3 : UCIP_FA_2015_5068.jpg

Inspector Comments: FS_ID:36689
 DS_ID:19891
 EP_NO: N/A
 FS_HLM: 19.822
 Repair Type: Non-Urgent
 Crossing Status: Found
 UCIP Comments: Dense vegetation limits the inspector's visibility to identify signs of pipe failure (leaks) along the slopes. Recommend removing vegetation along pipe alignment to conduct proper inspection of structure.
 FIELD_STRUCT_DESC: 2.5x2.5-foot R.C.B.C. through the levee, 14.0 feet below the crown. Flap gate on the waterward end. (USACE-1967). This entry matches the Drainage or Irrigation Structure referenced in O&M manual (HLM 19.85).
 FS Date: 04/17/2014

View of "U" concrete headwall located on waterward side.

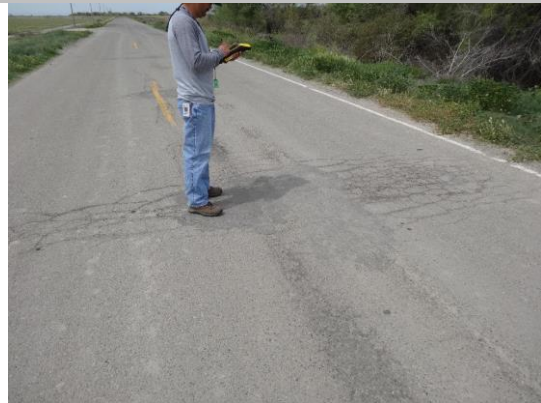
Photo 2 of 3 : UCIP_FA_2015_5069.jpg

Overview of levee crown looking downstream.

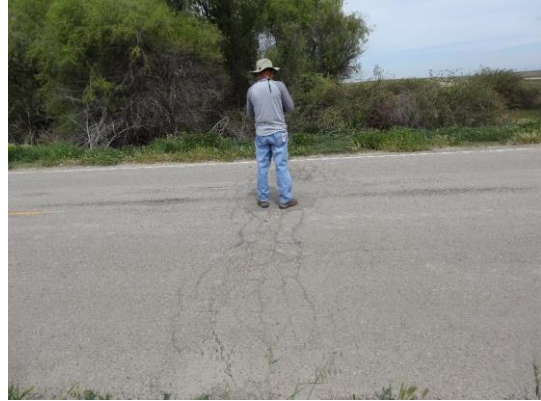
Photo 3 of 3 : UCIP_FA_2015_5070.jpg

LM Start	19.94	Rating **	M	Issue No.	1257 (cont)
LM End	19.94	Issue Type +	En	Location *	WS
Category	Supplemental			GPS Latitude/Longitude	
				Start	End
Item	DWR UCIP Field Study			37.113304 °	37.113304 °
				-120.579102 °	-120.579102 °
DWR ID					
Action/Comments					
Inspector Comments: FS_ID:36689					
DS_ID:19891					
EP_NO: N/A					
FS_HLM: 19.822					
Repair Type: Non-Urgent					
Crossing Status: Found

View of levee crown at crossing.

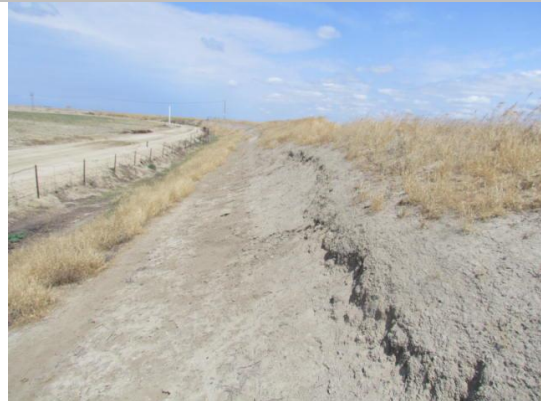
Photo 1 of 2 : FA_2015_NA0010_124_1209_20150914_00024.jpg

LM Start	20.79	Rating **	U	Issue No.	1209
LM End	20.88	Issue Type +	Ma	Location *	LS
Category	Earthen Levee			GPS Latitude/Longitude	
				Start	End
Item	Erosion / Bank Caving			37.113107 °	37.112176 °
				-120.563782 °	-120.562516 °
DWR ID	DWR_NA0010_06_s_2015_1209				
Action/Comments					
Note and monitor erosion site. Inspector Comments: Erosion on landward slope greater than 3 inches. Erosion caused by livestock.

Looking north at livestock erosion on landward slope.

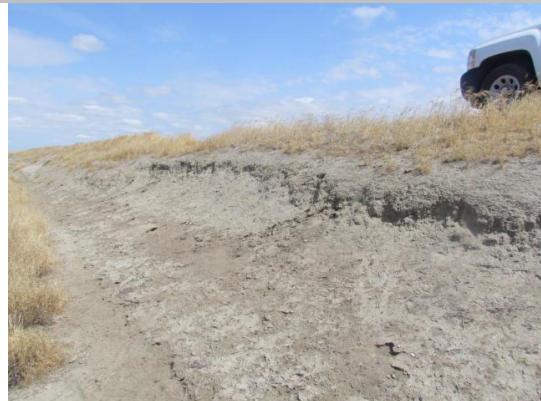
Photo 2 of 2 : FA_2015_NA0010_124_1209_20150914_00025.jpg

Looking northeast at livestock erosion on landward slope.

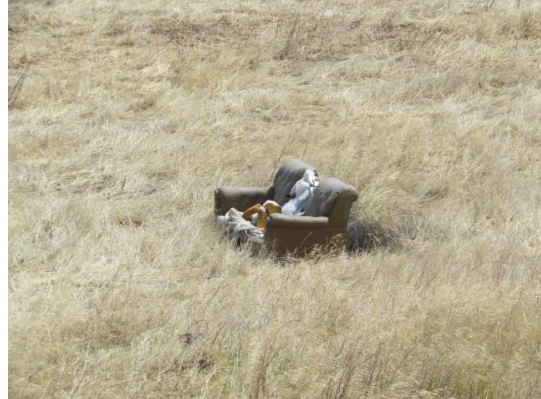
Photo 1 of 1 : FA_2015_NA0010_124_1210_20150914_00026.jpg

LM Start	20.83	Rating **	M	Issue No.	1210
LM End	20.83	Issue Type +	En	Location *	WS
Category	Earthen Levee			GPS Latitude/Longitude	
				Start	End
Item	Encroachments			37.112782 °	37.112782 °
				-120.563170 °	-120.563170 °
DWR ID	DWR_NA0010_06_s _ 2015_1210				
Action/Comments					
Garbage					
Inspector Comments: Garbage (sofa) dump on waterward berm about 100 plus feet away from waterward toe.

Looking east at garbage (soft) on waterward berm.

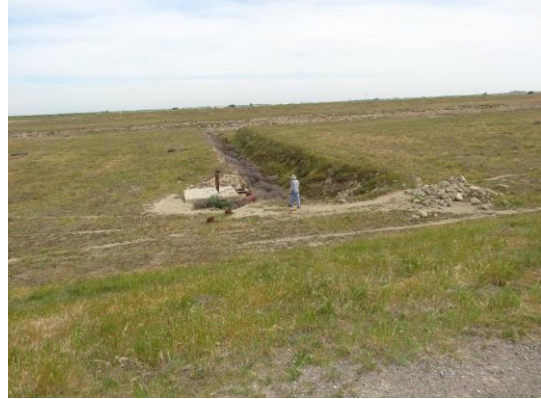
Photo 1 of 3 : UCIP_FA_2015_5671.jpg

Action/Comments					
Inspector Comments: FS_ID:34010 DS_ID:19879 EP_NO: 13638 FS_HLM: 23.929 Repair Type: Non-Urgent Crossing Status: Found UCIP Comments: Need to contact owner to determine status. Crossing has been modified. FIELD_STRUCT_DESC: 16-inch steel pipe through levee, 3.5 feet below crown. Pump on the waterside. Siphon breaker on the landward shoulder. Cutoff wall around pipe at center of levee. Intake trench on waterward side. (Permit No. 13638-1984) FS Date: 04/17/2014

View of waterward side.

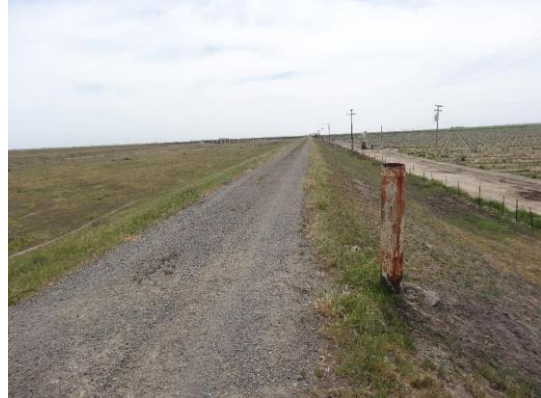
Photo 2 of 3 : UCIP_FA_2015_5672.jpg

Overview of levee crown at crossing.

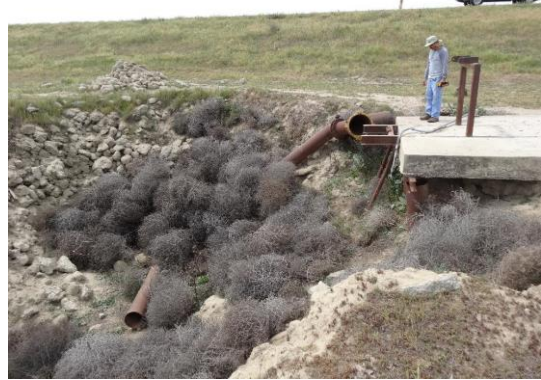
Photo 3 of 3 : UCIP_FA_2015_5673.jpg

LM Start	24.02	Rating **	M	Issue No.	1258 (cont)
LM End	24.02	Issue Type +	En	Location *	LS
Category	Supplemental			GPS Latitude/Longitude	
				Start	End
Item	DWR UCIP Field Study			37.077406 °	37.077406 °
				-120.525938 °	-120.525938 °
DWR ID					
Action/Comments					
Inspector Comments: FS_ID:34010					
DS_ID:19879					
EP_NO: 13638					
FS_HLM: 23.929					
Repair Type: Non-Urgent					
Crossing Status: Found

Concrete pad with abandoned support frame located on waterward side.

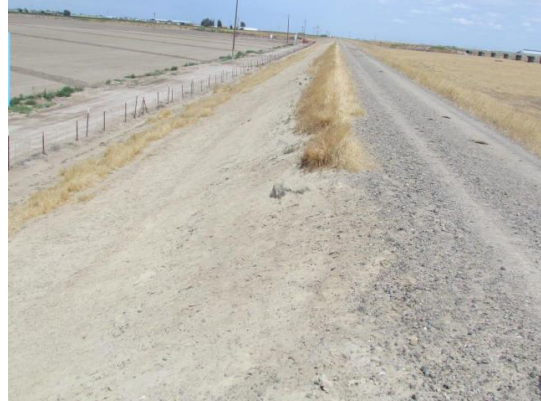
Photo 1 of 3 : FA_2015_NA0010_124_5_20150914_00008.jpg

LM Start	24.58	Rating **	M	Issue No.	5
LM End	24.93	Issue Type +	Ma	Location *	LS
Category	Earthen Levee			GPS Latitude/Longitude	
				Start	End
Item	Slope Stability			37.071198 °	°
				-120.519220 °	°
DWR ID	DWR_NA0010_06_s_2012_5				
Action/Comments					
Repair the levee slope damaged by foot traffic and prevent access where possible.					
Inspector Comments: Landside erosion caused by livestock.

Looking north at livestock erosion on landward slope. (Spring 2015)

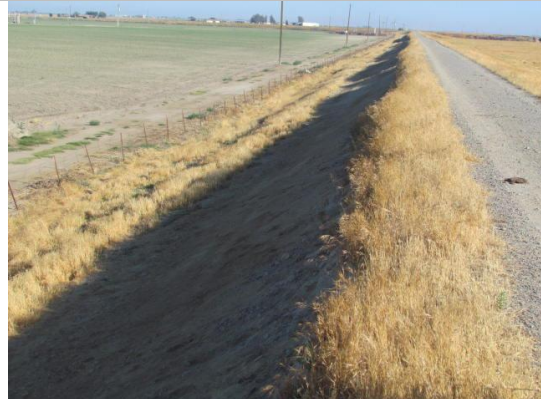
Photo 2 of 3 : FA_2015_NA0010_124_5_20150914_00009.jpg

Looking north at livestock erosion on landward slope. (Spring 2014)

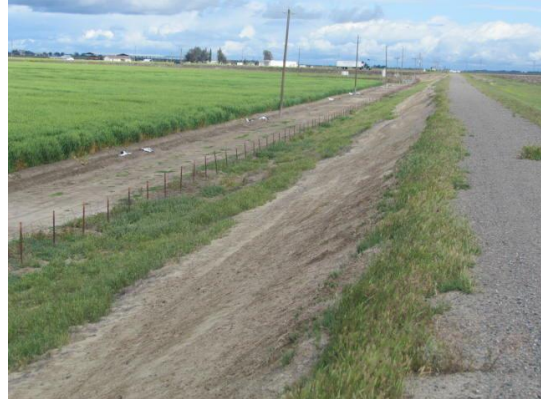
Photo 3 of 3 : FA_2015_NA0010_124_5_20150914_00010.jpg

LM Start	24.58	Rating **	M	Issue No.	5 (cont)	
LM End	24.93	Issue Type +	Ma	Location *	LS	
Category	Earthen Levee			GPS Latitude/Longitude		
				Start		End
Item	Slope Stability			37.071198 °		°
				-120.519220 °		°
DWR ID	DWR_NA0010_06_s _ 2012_5					
Action/Comments						
Repair the levee slope damaged by foot traffic and prevent access where possible.						
Inspector Comments: Landside erosion caused by livestock.

Looking north at livestock erosion on landside slope. (Fall 2014)

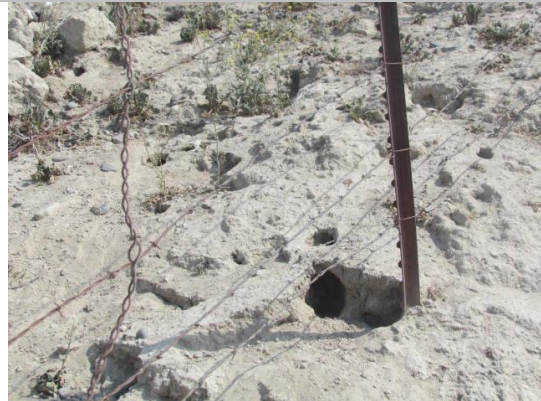
Photo 1 of 1 : FA_2015_NA0010_124_1208_20150914_00023.jpg

LM Start	26.13	Rating **	M	Issue No.	1208
LM End	26.13	Issue Type +	Ma	Location *	LS
Category	Earthen Levee			GPS Latitude/Longitude	
				Start	End
Item	Animal Control			37.054222 °	37.054222 °
				-120.500862 °	-120.500862 °
DWR ID	DWR_NA0010_06_s _ 2015_1208				
Action/Comments					
Exterminate rodents and backfill and compact or grout burrows. Inspector Comments: Noted several rodent holes next to and within rock revertment on landward slope.

Looking northeast at several rodent holes on landward slope.

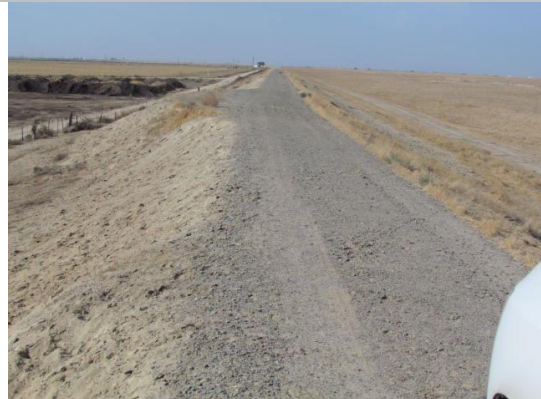
Photo 1 of 4 : FA_2015_NA0010_124_3_20151013_00043.jpg

LM Start	27.64	Rating **	M	Issue No.	3
LM End	27.97	Issue Type +	Ma	Location *	LS
Category	Earthen Levee			GPS Latitude/Longitude	
				Start	End
Item	Slope Stability			37.036955 °	37.032887 °
				-120.484395 °	-120.481225 °
DWR ID	DWR_NA0010_06_s _ 2012_3				
Action/Comments					
Repair the levee slope damaged by foot traffic and prevent access where possible.					
Inspector Comments: Landside erosion caused by livestock. Erosion greater than 3" in depth on landward slope. Levee crown has narrowed within this reach.

Looking north at livestock erosion on landward slope. Fall 2015

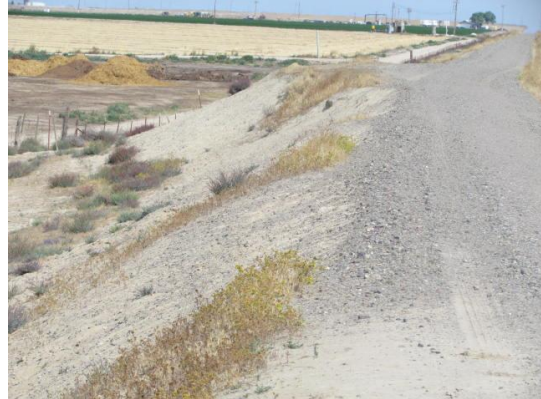
Photo 2 of 4 : FA_2015_NA0010_124_3_20150914_00003.jpg

LM Start	27.64	Rating **	M	Issue No.	3 (cont)
LM End	27.97	Issue Type +	Ma	Location *	LS
Category	Earthen Levee			GPS Latitude/Longitude	
				Start	End
Item	Slope Stability			37.036955 °	37.032887 °
				-120.484395 °	-120.481225 °
DWR ID	DWR_NA0010_06_s _ 2012_3				
Action/Comments					
Repair the levee slope damaged by foot traffic and prevent access where possible. Inspector Comments: Landside erosion caused by livestock. Erosion greater than 3" in depth on landward slope. Levee crown has narrowed within this reach.

Looking north at livestock erosion on landward shoulder and slope.(Spring 2015)

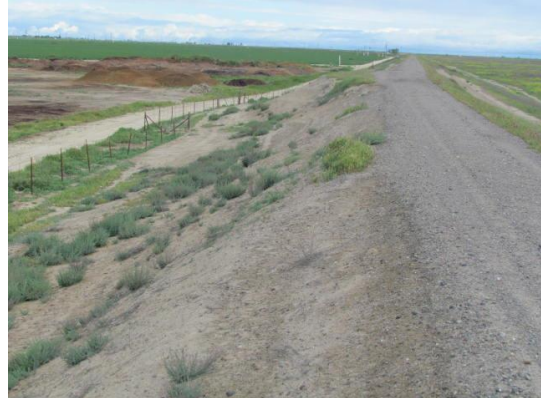
Photo 3 of 4 : FA_2015_NA0010_124_3_20150914_00004.jpg

Looking north at livestock erosion on landside shoulder and slope. (Fall 2014)

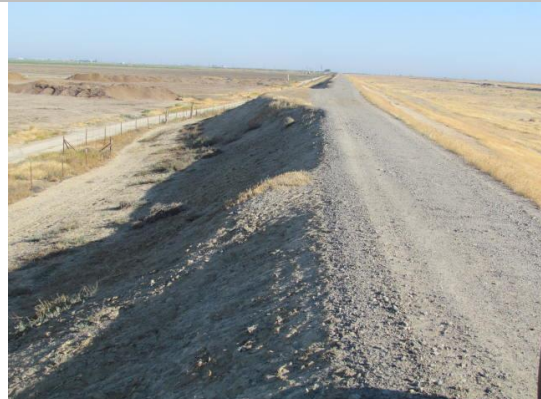
Photo 4 of 4 : FA_2015_NA0010_124_3_20150914_00006.jpg

Looking north at livestock erosion on landward slope. (Spring 2013)

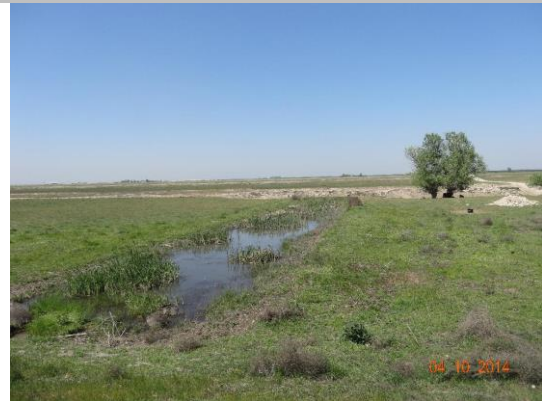
Photo 1 of 3 : UCIP_FA_2015_5071.jpg

LM Start	29.44	Rating **	M	Issue No.	1259
LM End	29.44	Issue Type +	En	Location *	LS
Category	Supplemental			GPS Latitude/Longitude	
				Start	End
Item	DWR UCIP Field Study			37.030369 °	37.030369 °
				-120.455969 °	-120.455969 °
DWR ID					
Action/Comments					
Inspector Comments: FS_ID:39886 DS_ID:19881 EP_NO: N/A FS_HLM: 29.35 Repair Type: Non-Urgent Crossing Status: Found UCIP Comments: Dense vegetation limits the inspector's visibility to identify signs of pipe failure (leaks) along the slopes. Recommend removing vegetation along pipe alignment to conduct proper inspection of structure. FIELD_STRUCT_DESC: 36-inch CM pipe through levee, 12.4 feet below crown. Slide gate in 48-inch CM pipe riser in the waterward slope. Concrete "U" headwall on both ends. Cobble pad on the landward side. (USACE-1967). This entry matches the Drainage or Irrigation Structure referenced in O&M manual (HLM 29.34). FS Date: 04/10/2014

View of waterward side.

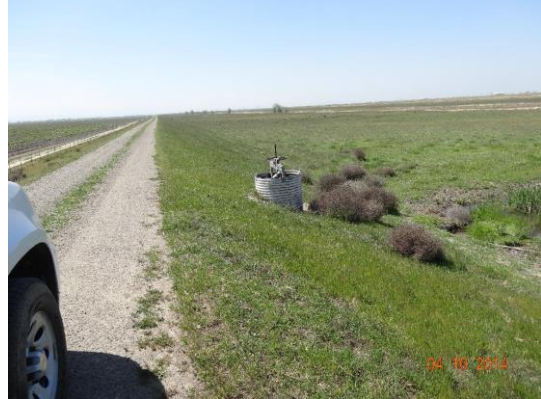
Photo 2 of 3 : UCIP_FA_2015_5072.jpg

View of waterward side--slide gate inside CMP riser located on waterward slope.

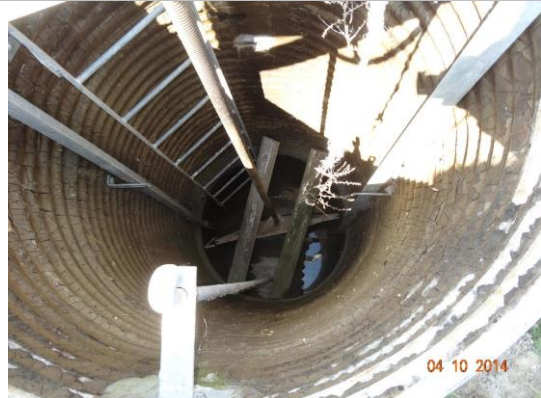
Photo 3 of 3 : UCIP_FA_2015_5073.jpg

Inside view of CMP riser located on waterward slope.

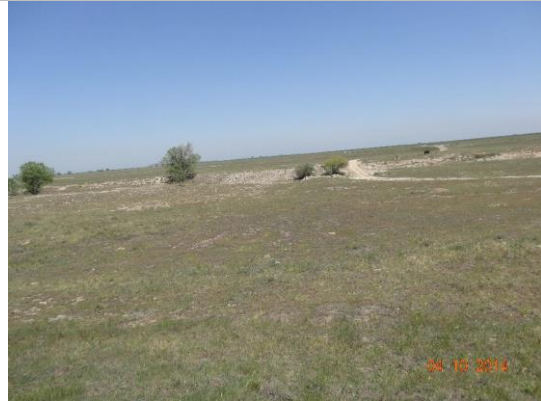
Photo 1 of 3 : UCIP_FA_2015_5074.jpg

LM Start	30.36	Rating **	M	Issue No.	1260
LM End	30.36	Issue Type +	En	Location *	LS
Category	Supplemental			GPS Latitude/Longitude	
				Start	End
Item	DWR UCIP Field Study			37.027330 °	37.027330 °
				-120.441498 °	-120.441498 °
DWR ID					
Action/Comments					
Inspector Comments: FS_ID:36693					
DS_ID:19882					
EP_NO: N/A					
FS_HLM: 30.27					
Repair Type: Non-Urgent					
Crossing Status: Found

Overview of Eastside Bypass at crossing.

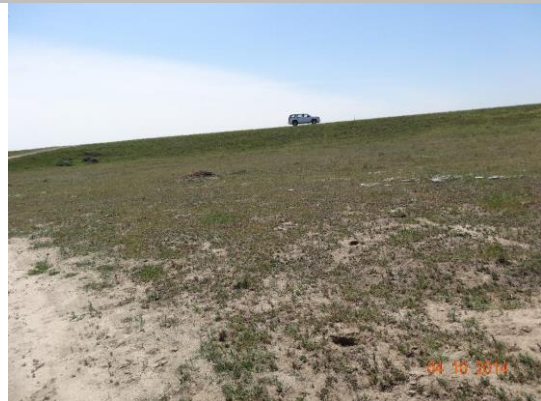
Photo 2 of 3 : UCIP_FA_2015_5075.jpg

Overview of waterward side.

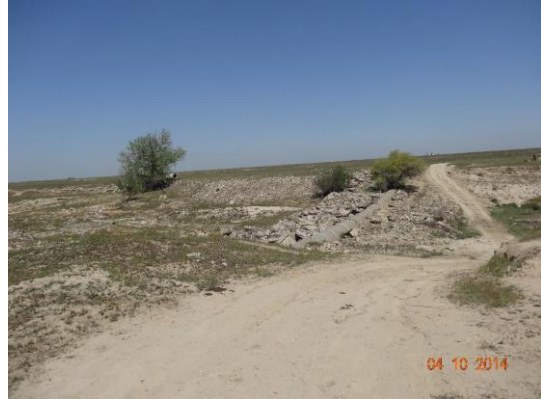
Photo 3 of 3 : UCIP_FA_2015_5076.jpg

LM Start	30.36	Rating **	M	Issue No.	1260 (cont)
LM End	30.36	Issue Type +	En	Location *	LS
Category	Supplemental			GPS Latitude/Longitude	
				Start	End
Item	DWR UCIP Field Study			37.027330 °	37.027330 °
				-120.441498 °	-120.441498 °
DWR ID					
Action/Comments					
Inspector Comments: FS_ID:36693 DS_ID:19882 EP_NO: N/A FS_HLM: 30.27 Repair Type: Non-Urgent Crossing Status: Found

Concrete pipe through Eastside Bypass exposed.

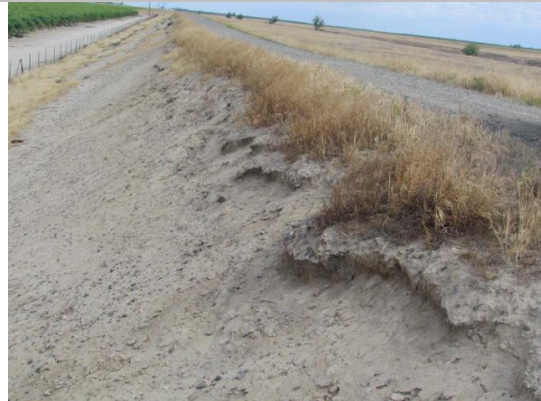
Photo 1 of 2 : FA_2015_NA0010_124_1207_20150914_00021.jpg

LM Start	30.81	Rating **	U	Issue No.	1207
LM End	31.06	Issue Type +	Ma	Location *	LS
Category	Earthen Levee			GPS Latitude/Longitude	
				Start	End
Item	Erosion / Bank Caving			37.021615 °	37.018428 °
				-120.437587 °	-120.435378 °
DWR ID	DWR_NA0010_06_s_2015_1207				
Action/Comments					
Note and monitor erosion site. Inspector Comments: Landward erosion greater than 1" in depth and greater than 3" in length. Erosion caused by livestock traffic.

Looking northeast at livestock erosion on landward slope.

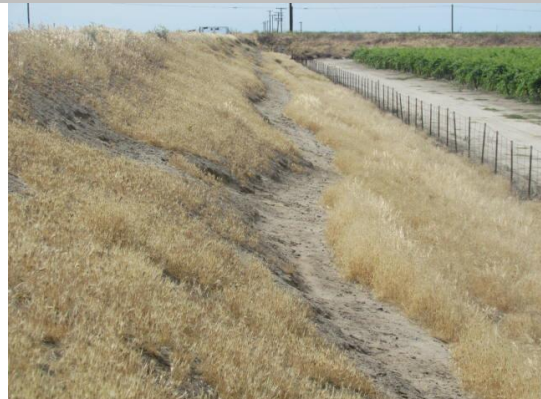
Photo 2 of 2 : FA_2015_NA0010_124_1207_20150914_00022.jpg

Looking south at livestock erosion on landward slope.

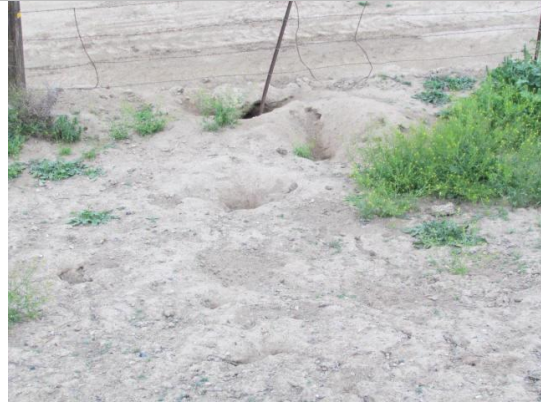
Photo 1 of 2 : FA_2015_NA0010_124_2_20150914_00001.jpg

Looking west at rodent holes on landside slope and toe near fence line.

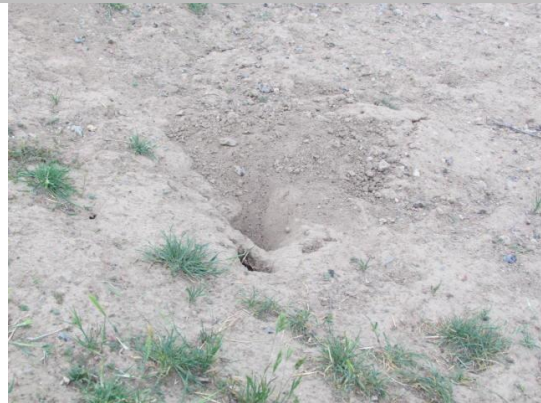
Photo 2 of 2 : FA_2015_NA0010_124_2_20150914_00002.jpg

Looking at typical rodent hole on landside slope.

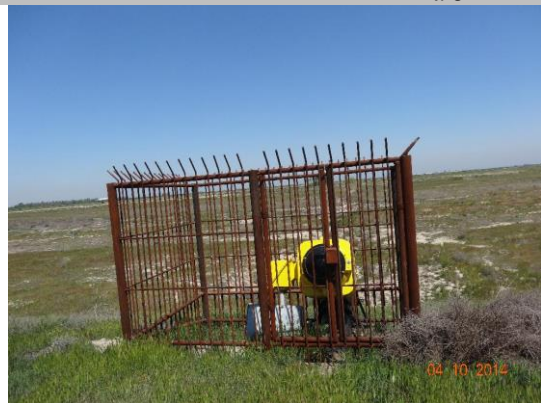
Photo 1 of 3 : UCIP_FA_2015_4046.jpg

LM Start	33.08	Rating **	M	Issue No.	1261
LM End	33.08	Issue Type +	En	Location *	LS
Category	Supplemental			GPS Latitude/Longitude	
				Start	End
Item	DWR UCIP Field Study			36.995672 °	36.995672 °
				-120.412919 °	-120.412919 °
DWR ID					
Action/Comments					
Inspector Comments: FS_ID:46183					
DS_ID:19883					
EP_NO: 6416A					
FS_HLM: 32.99					
Repair Type: Non-Urgent					
Crossing Status: Found

Electrical conduit visible on waterward slope.

Inspector Comments: FS_ID:46183
 DS_ID:19883
 EP_NO: 6416A
 FS_HLM: 32.99
 Repair Type: Non-Urgent
 Crossing Status: Found
 UCIP Comments: Crossing updated--need to contact owner to determine permit issued by CVFPB for authorized changes.
 FIELD_STRUCT_DESC: 20-inch (not 18 inch as mentioned in DS study) steel pipe through the levee, 3.9 feet below crown. Electrical conduit through levee. Capped with welded plate on landward end. Siphon breaker on apex of pipe on the landward shoulder. Cutoff wall around pipe at centerline of levee. Slant pump on waterward slope.
 (Permit No. 6416A-1980)
 FS Date: 04/10/2014

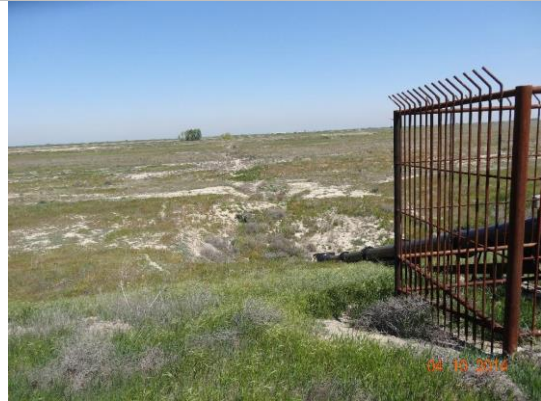
Photo 2 of 3 : UCIP_FA_2015_4047.jpg

View of Eastside Bypass.

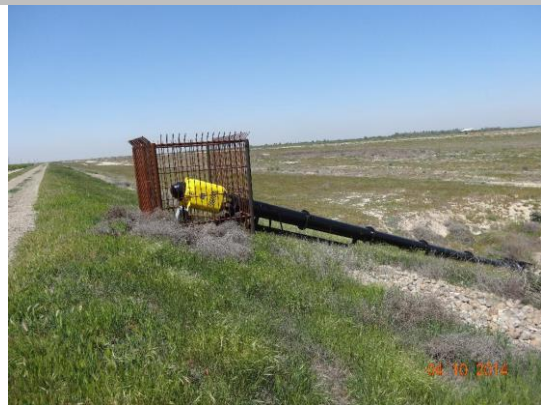
Photo 3 of 3 : UCIP_FA_2015_5705.jpg

View of waterward side--pipe and pump fenced off on waterward slope.

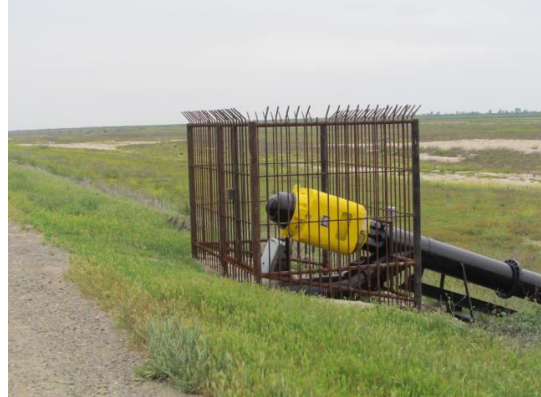
Photo 1 of 1 : FA_2015_NA0010_124_123_20150914_00020.jpg

LM Start	33.08	Rating **	M	Issue No.	123
LM End	33.08	Issue Type +	En	Location *	WS
Category	Earthen Levee			GPS Latitude/Longitude	
				Start	End
Item	Encroachments			36.995667 °	36.995667 °
				-120.412910 °	-120.412910 °
DWR ID	DWR_NA0010_06_s _ 2012_123				
Action/Comments					
Fence					
Inspector Comments: Landowner constructed a metal fence around slant pump without a permit.

Looking northeast at new metal fence around slant pump on waterside slope.

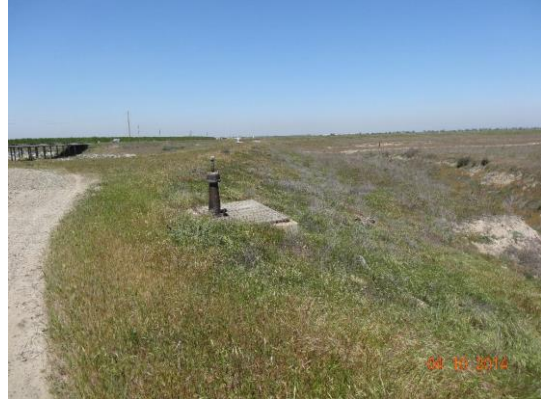
Photo 1 of 3 : UCIP_FA_2015_5115.jpg

View of waterward side--slide gate inside concrete box.

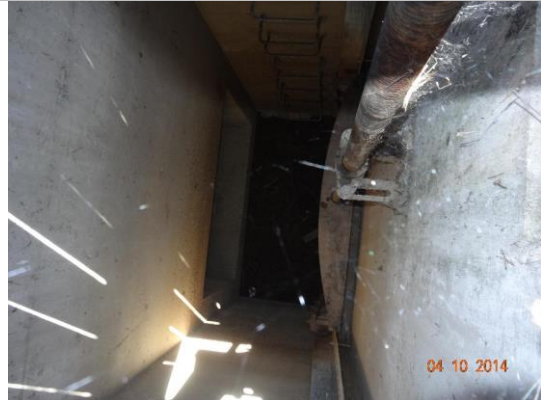
Photo 2 of 3 : UCIP_FA_2015_5742.jpg

Inside view of concrete box located on waterward slope.

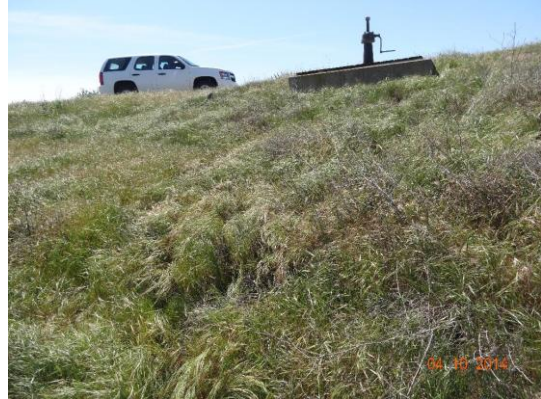
Photo 3 of 3 : UCIP_FA_2015_5743.jpg

View of waterward slope covered by dense vegetation.

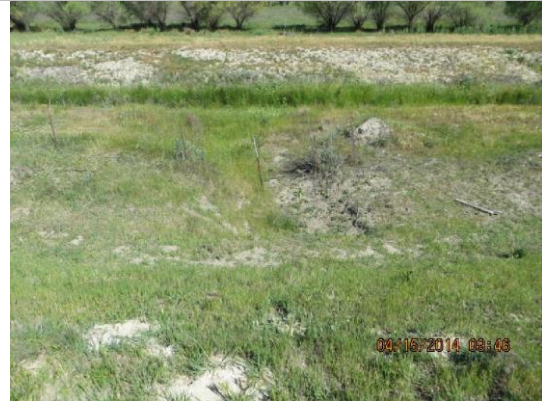
Photo 1 of 3 : UCIP_FA_2015_4442.jpg

Pipe and headwall at LS toe.

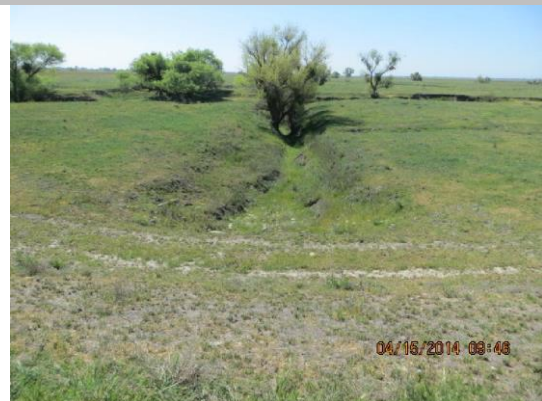
Photo 2 of 3 : UCIP_FA_2015_4443.jpg

Pipe and headwall at WS toe.

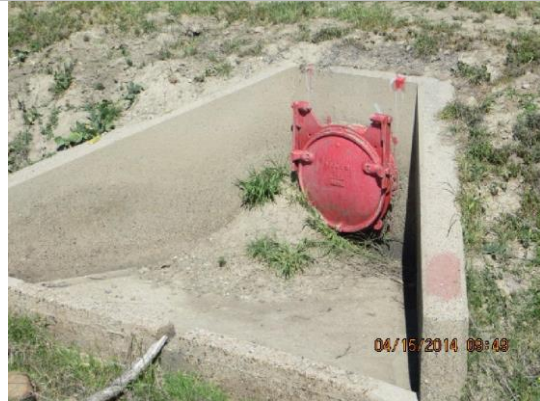
Photo 3 of 3 : UCIP_FA_2015_4444.jpg

Inspector Comments: FS_ID:41131
 DS_ID:19892
 EP_NO: N/A
 FS_HLM: 0.072
 Repair Type: Urgent
 Crossing Status: Found
 UCIP Comments: Flapgate partially blocked by soil buildup at WS toe.
 FIELD_STRUCT_DESC: 24-inch C.M stormdrain pipe through the levee, 10.8 feet below the crown. Flap gate on the waterward end. Concrete headwall on the landward end. Concrete "U" headwall on the waterward end. (USACE-1967). This entry matches the Drainage or Irrigation Structure referenced in O&M manual (HLM 0.07).
 FS Date: 04/15/2014

Pipe, headwall, and flapgate at WS toe. Soil buildup partially blocking flapgate.

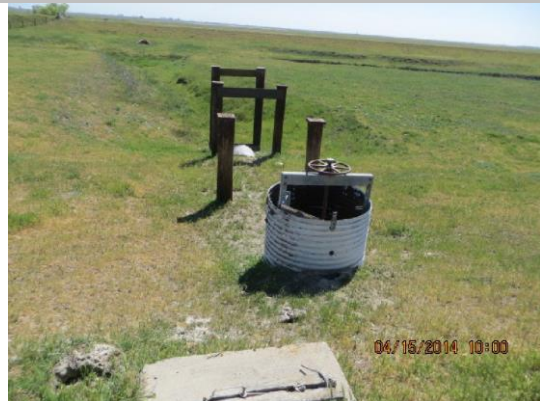
Photo 1 of 3 : UCIP_FA_2015_4560.jpg

Slide gate in CMP riser on WS slope.

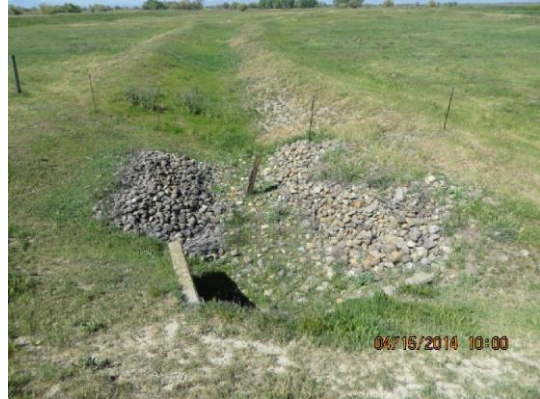
Photo 2 of 3 : UCIP_FA_2015_4561.jpg

Pipe and headwall on LS toe.

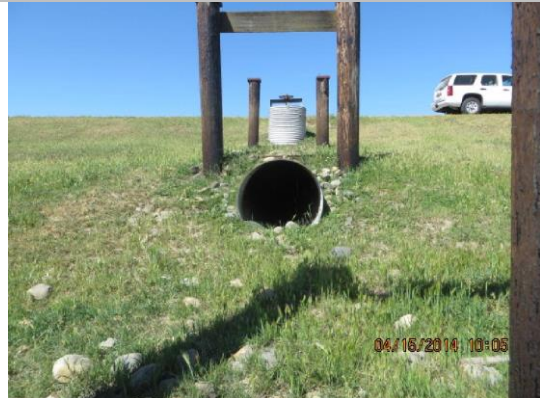
Photo 3 of 3 : UCIP_FA_2015_4562.jpg

Outlet on WS slope.

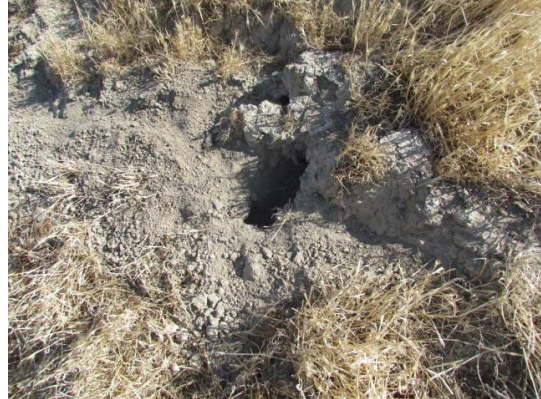
Photo 1 of 1 : FA_2015_NA0010_125_29_20150914_00011.jpg

LM Start	0.50	Rating **	M	Issue No.	29
LM End	0.50	Issue Type +	Ma	Location *	LS
Category	Earthen Levee			GPS Latitude/Longitude	
				Start	End
Item	Animal Control			37.258722 °	37.258722 °
				-120.764867 °	-120.764867 °
DWR ID	DWR_NA0010_07_s _ 2012_29				
Action/Comments					
No rodents visible, but rodent burrows visible; need to backfill and compact or grout burrows. Inspector Comments: Several rodent holes noted on landward and waterward slope and shoulder.

Looking at typical view of rodent holes on landward slope.

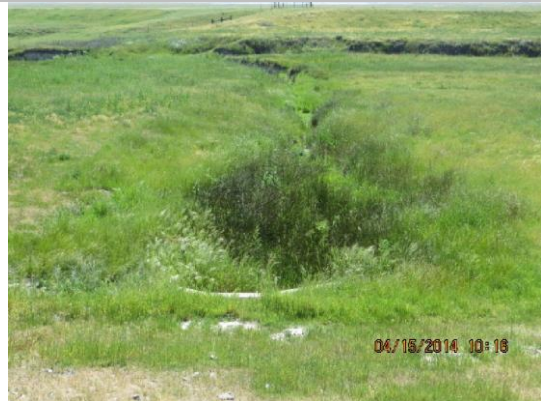
Photo 1 of 3 : UCIP_FA_2015_4577.jpg

Headwall and flapgate on WS toe.

Inspector Comments: FS_ID:39507
 DS_ID:19896
 EP_NO: N/A
 FS_HLM: 0.849
 Repair Type: Non-Urgent
 Crossing Status: Found
 UCIP Comments: Need to contact owner. Heavy sediment buildup at inlet due to animal activity should be cleared.
 FIELD_STRUCT_DESC: 24-inch C.M. stormdrain pipe through the levee, 9.8-feet below the crown. Flap gate on the waterward end.
 Wooden weir on concrete headwall at the LS toe. 36-inch concrete riser at LS toe. Concrete "U" headwall on the waterward end. Concrete standpipe on landward side. (USACE-1967). This entry matches the Drainage or Irrigation Structure referenced in O&M manual (HLM 0.85).
 FS Date: 04/15/2014

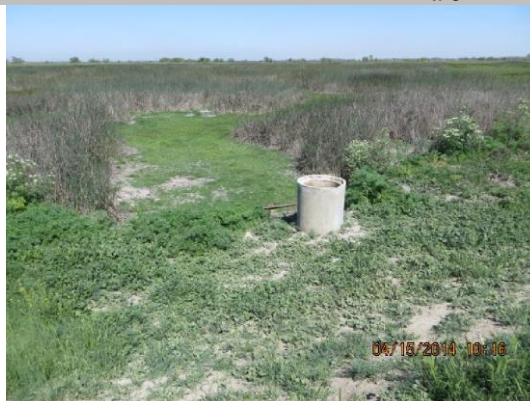
Photo 2 of 3 : UCIP_FA_2015_4578.jpg

Concrete riser, concrete headwall, weir, and pipe at LS toe.

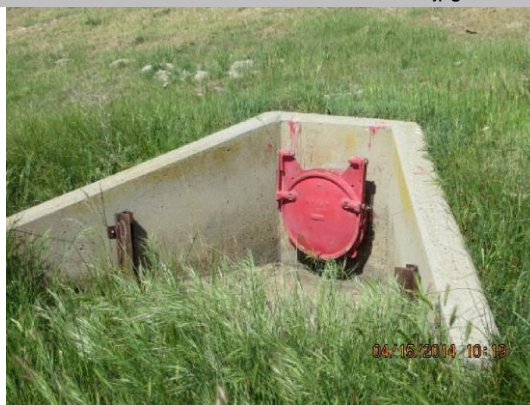
Photo 3 of 3 : UCIP_FA_2015_4579.jpg

Headwall and flapgate on WS toe.

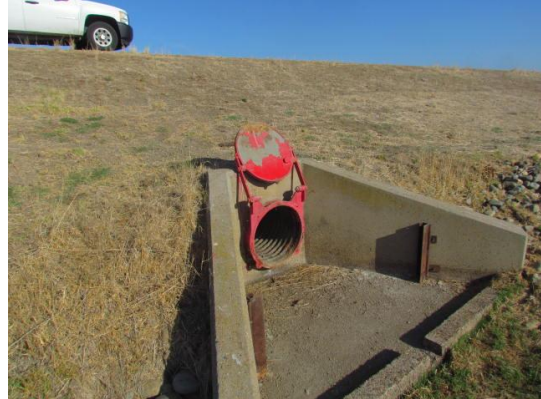
Photo 1 of 1 : FA_2015_NA0010_125_10_20151014_00013.jpg

LM Start	0.85	Rating **	M	Issue No.	10
LM End	0.85	Issue Type +	Ma	Location *	WS
Category	Interior Drainage & Piping Systems			GPS Latitude/Longitude	
				Start	End
Item	Flap Gates			37.262991 °	37.262991 °
				-120.761711 °	-120.761711 °
DWR ID	DWR_NA0010_07_f _ 2015_10				
Action/Comments					
Inspector Comments: Flap gate is open and should be closed during flood season.

Looking at flap gate left open on waterward slope.

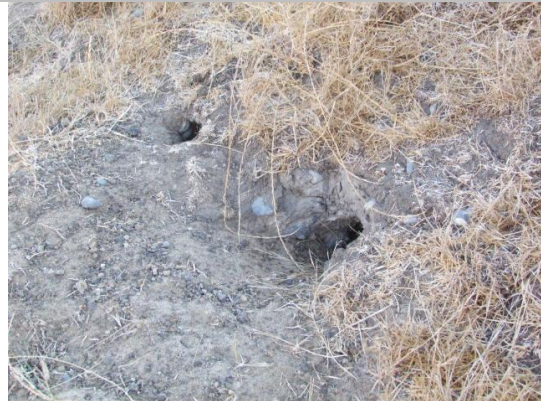
Photo 1 of 2 : FA_2015_NA0010_125_1_20150914_00001.jpg

Looking north at several rodent holes on landward slope.

LM Start	1.22	Rating **	M	Issue No.	1
LM End	1.22	Issue Type +	Ma	Location *	LS
Category	Earthen Levee			GPS Latitude/Longitude	
				Start	End
Item	Animal Control			37.264387 °	37.264387 °
				-120.755805 °	-120.755805 °
DWR ID	DWR_NA0010_07_f_2012_1				
Action/Comments					
Exterminate rodents and backfill and compact or grout burrows.

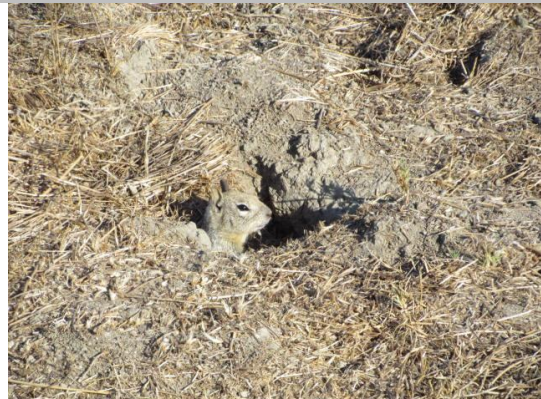
Photo 2 of 2 : FA_2015_NA0010_125_1_20150914_00002.jpg

Looking at east at active rodent holes on landside berm.

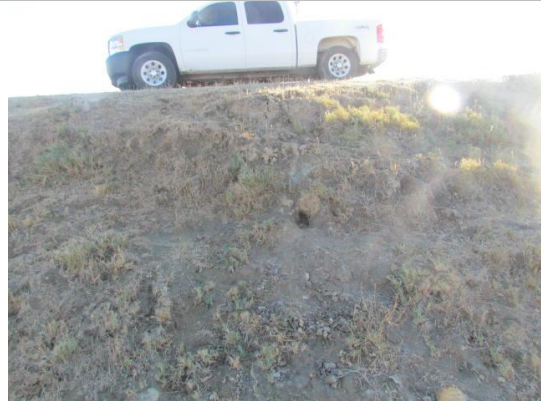
Photo 1 of 1 : FA_2015_NA0010_125_11_20150914_00009.jpg

LM Start	1.25	Rating **	A/W	Issue No.	11
LM End	1.25	Issue Type +	Ma	Location *	LS
Category	Earthen Levee			GPS Latitude/Longitude	
				Start	End
Item	Slope Stability			37.264367 °	37.264367 °
				-120.755218 °	-120.755218 °
DWR ID	DWR_NA0010_07_f_2014_11				
Action/Comments					
Repair the levee slope damaged by foot traffic and prevent access where possible.					
Inspector Comments: Slope damage caused by livestock and rodent activity.

Looking west at slope damage and rodent activity on landward slope.

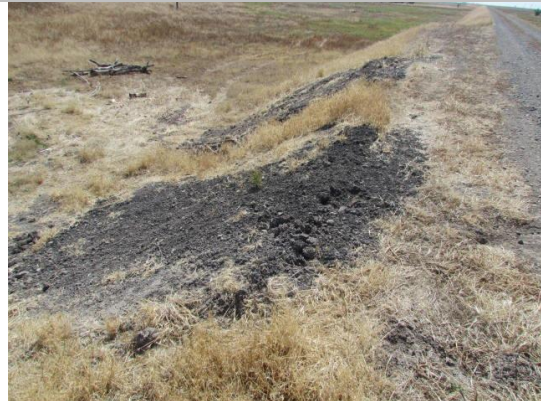
Photo 1 of 5 : FA_2015_NA0010_125_3_20150914_00003.jpg

LM Start	1.50	Rating **	A/W	Issue No.	3
LM End	1.50	Issue Type +	Ma	Location *	LS
Category	Earthen Levee			GPS Latitude/Longitude	
				Start	End
Item	Animal Control			37.263930 °	37.263930 °
				-120.750680 °	-120.750680 °
DWR ID	DWR_NA0010_07_s_2012_3				
Action/Comments					
Repair the levee slope damaged by livestock and prevent large animal access.					
Inspector Comments: Erosion on landward slope has been repaired by district. Landward toe erosion not repaired.

Looking east at repaired landward slope.

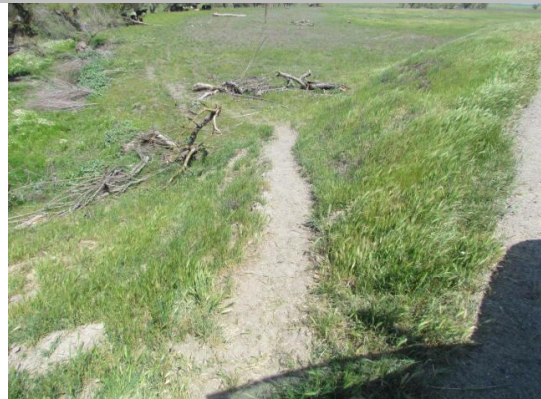
Photo 2 of 5 : FA_2015_NA0010_125_3_20150914_00004.jpg

Looking northeast at landside slope damaged by livestock.

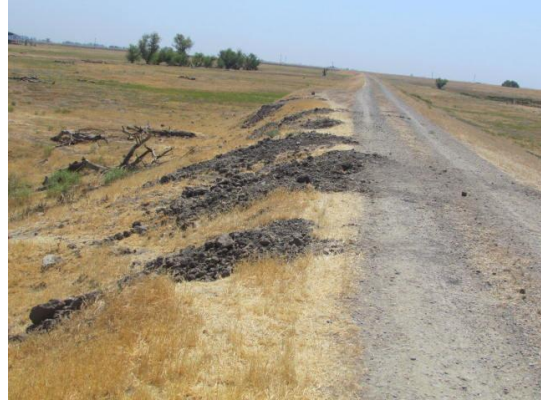
Photo 3 of 5 : FA_2015_NA0010_125_3_20150914_00005.jpg

Looking south at landward slope.

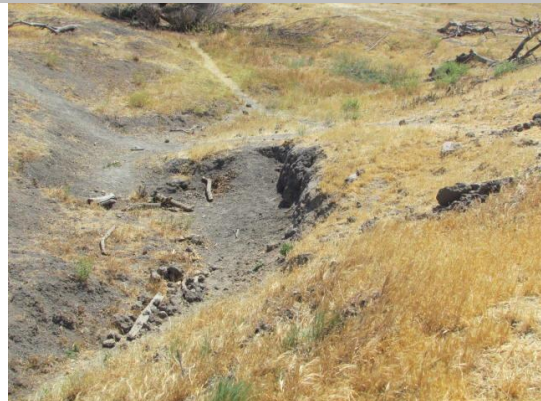
Photo 4 of 5 : FA_2015_NA0010_125_3_20150914_00006.jpg

Looking southeast at damage on landward toe.(Spring 2013)

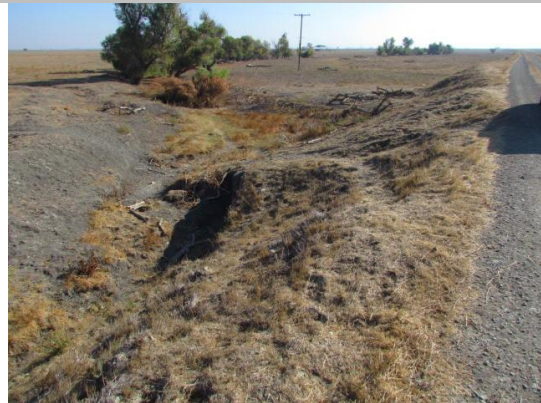
Photo 5 of 5 : FA_2015_NA0010_125_3_20150914_00007.jpg

Looking southeast at landside slope and toe damage by livestock.

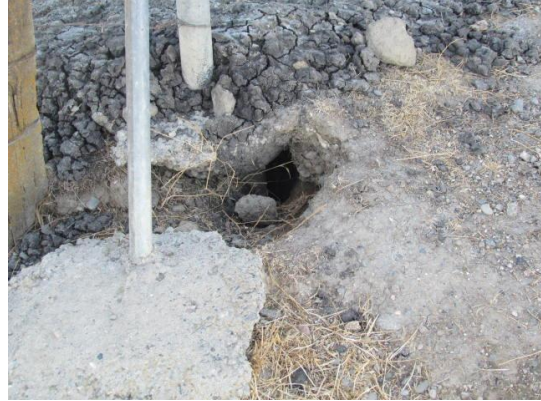
Photo 1 of 1 : FA_2015_NA0010_125_12_20150914_00010.jpg

LM Start	2.09	Rating **	M	Issue No.	12
LM End	2.09	Issue Type +	Ma	Location *	LS
Category	Earthen Levee			GPS Latitude/Longitude	
				Start	End
Item	Animal Control			37.259187 °	37.259187 °
				-120.742551 °	-120.742551 °
DWR ID	DWR_NA0010_07_f_2014_12				
Action/Comments					
No rodents visible, but rodent burrows visible; need to backfill and compact or grout burrows.					
Inspector Comments: Rodent activity noted next to fence post.

Looking east at rodent hole next to fence post on landward shoulder.

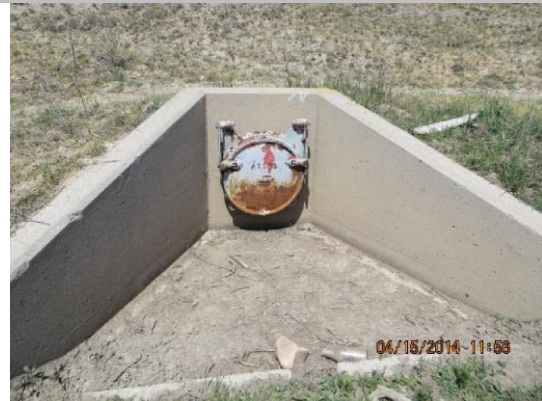
Photo 1 of 3 : UCIP_FA_2015_4580.jpg

Inspector Comments: FS_ID:39508
 DS_ID:19901
 EP_NO: N/A
 FS_HLM: 3.09
 Repair Type: Non-Urgent
 Crossing Status: Found
 UCIP Comments: Some sediment buildup at landward toe and inside pipe--recommend clearing.
 FIELD_STRUCT_DESC: 24-inch C.M. stormdrain pipe through the levee, 10.4-feet below the crown. Flap gate on the waterward end. Concrete headwall on the landward end. Concrete "U" headwall on the waterward end. (USACE-1967). This entry matches the Drainage or Irrigation Structure referenced in O&M manual (HLM 3.09).
 FS Date: 04/15/2014

Headwall, pipe, and flapgate on WS toe.

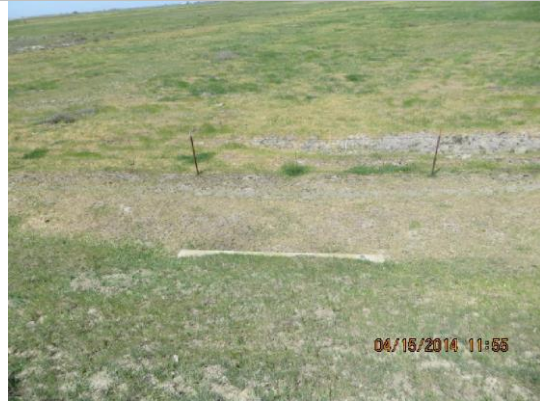
Photo 3 of 3 : UCIP_FA_2015_4582.jpg

Headwall and pipe on LS toe.

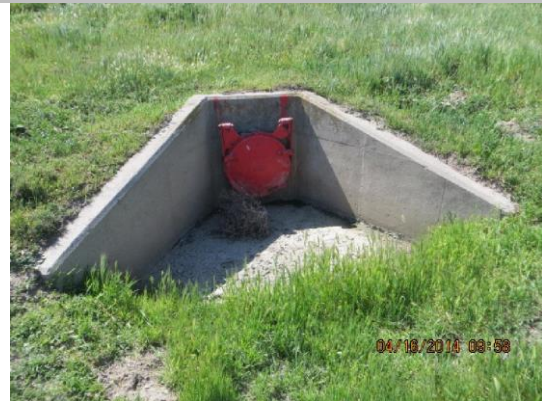
Photo 1 of 3 : UCIP_FA_2015_3861.jpg

Headwall, pipe, and flapgate on WS toe.

Action/Comments					
Inspector Comments: FS_ID:39887 DS_ID:19832 EP_NO: N/A FS_HLM: 0.899 Repair Type: Non-Urgent Crossing Status: Found UCIP Comments: Some sediment buildup at inlet on LS toe. FIELD_STRUCT_DESC: 24-inch CM stormdrain pipe through levee, 11.5 feet below crown. Flap gate on the waterward end. Concrete headwalls. (USACE-1967). This entry matches the Drainage or Irrigation Structure referenced in O&M manual (HLM 0.89). FS Date: 04/16/2014

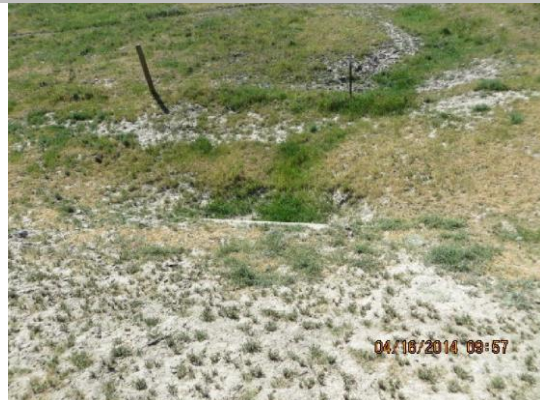
Photo 3 of 3 : UCIP_FA_2015_3863.jpg

Pipe and headwall on LS toe.

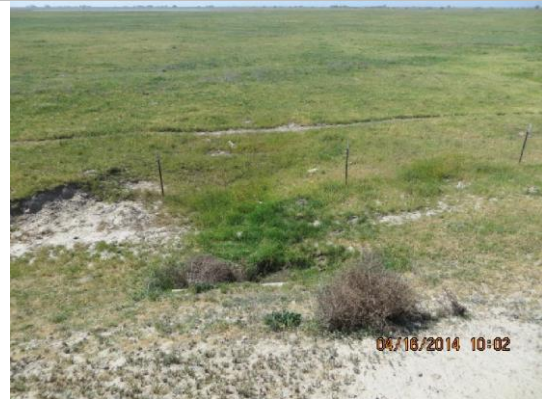
Photo 1 of 3 : UCIP_FA_2015_3864.jpg

Pipe and headwall on LS toe.

Inspector Comments: FS_ID:39509
 DS_ID:19833
 EP_NO: N/A
 FS_HLM: 1.209
 Repair Type: Non-Urgent
 Crossing Status: Found
 UCIP Comments: Debris blocking landward headwall--recommend clearing.
 FIELD_STRUCT_DESC: 24-inch CM stormdrain pipe through levee, 11.6 feet below crown. Flap gate on the waterward end. Concrete headwalls. (USACE-1967). This entry matches the Drainage or Irrigation Structure referenced in O&M manual (HLM 1.21).
 FS Date: 04/16/2014

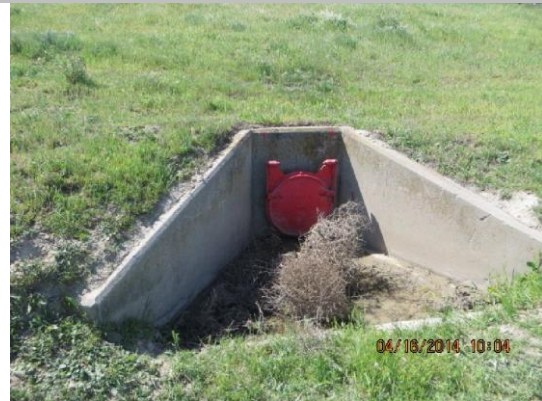
Photo 3 of 3 : UCIP_FA_2015_3866.jpg

Concrete headwall, pipe, and flapgate on WS toe.

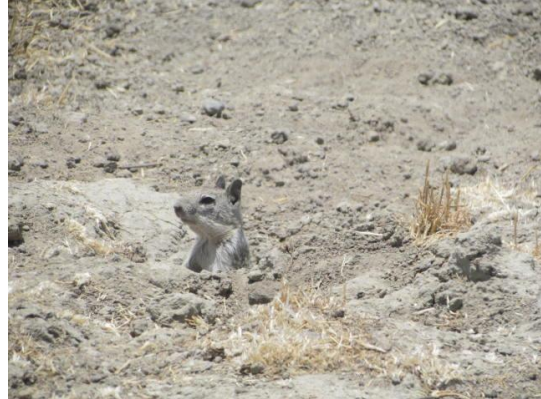
Photo 1 of 1 : FA_2015_NA0010_126_8_20150914_00006.jpg

Looking west at rodent holes on landward slope.

LM Start	1.38	Rating **	M	Issue No.	8
LM End	1.38	Issue Type +	Ma	Location *	LS
Category	Earthen Levee			GPS Latitude/Longitude	
				Start	End
Item	Animal Control			37.263175 °	37.263175 °
				-120.752307 °	-120.752307 °
DWR ID	DWR_NA0010_08_s_2013_8				
Action/Comments					
Exterminate rodents and backfill and compact or grout burrows.

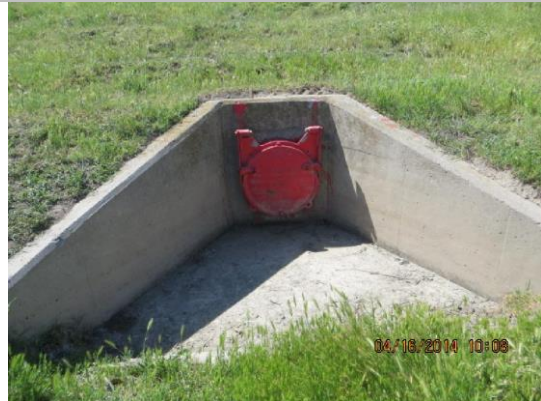
Photo 1 of 3 : UCIP_FA_2015_3867.jpg

Pipe, headwall, and flapgate on WS toe.

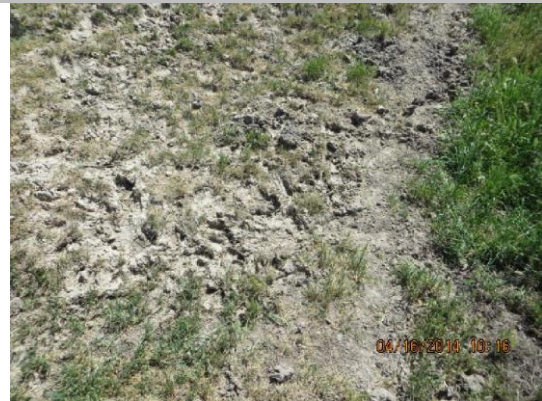
Photo 1 of 3 : UCIP_FA_2015_3965.jpg

Pipe and headwall buried in sediment at LS toe.

Inspector Comments: FS_ID:39511
 DS_ID:19835
 EP_NO: N/A
 FS_HLM: 2.045
 Repair Type: Non-Urgent
 Crossing Status: Found
 UCIP Comments: Non-functional landward inlet is buried in sediment.
 Need to contact owner to determine status.
 FIELD_STRUCT_DESC: 24-inch CM stormdrain pipe through levee,
 12.0 feet below crown. Flap gate on the waterward end. Concrete
 headwall on both ends. (USACE-1967). This entry matches the
 Drainage or Irrigation Structure referenced in O&M manual (HLM 2.05).
 FS Date: 04/16/2014

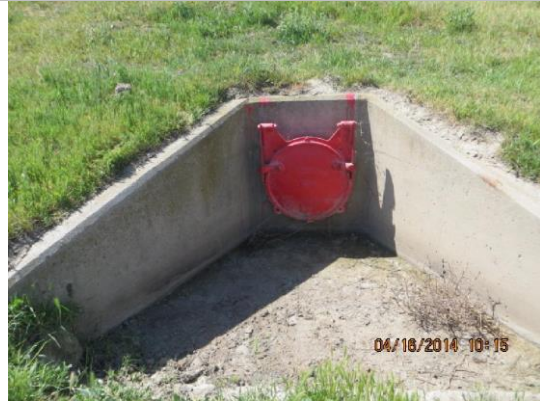
Photo 2 of 3 : UCIP_FA_2015_3966.jpg

Pipe, headwall, and flapgate on Ws toe.

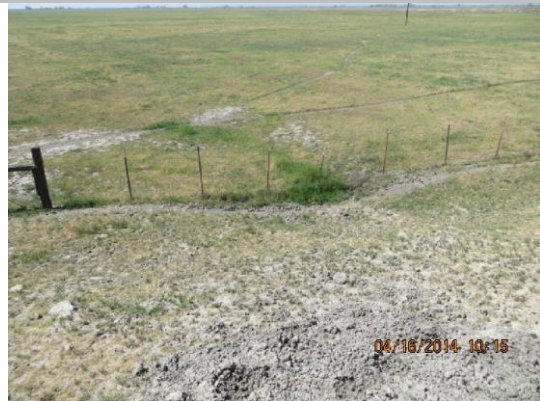
Photo 3 of 3 : UCIP_FA_2015_3967.jpg

Pipe and headwall buried in sediment at LS toe.

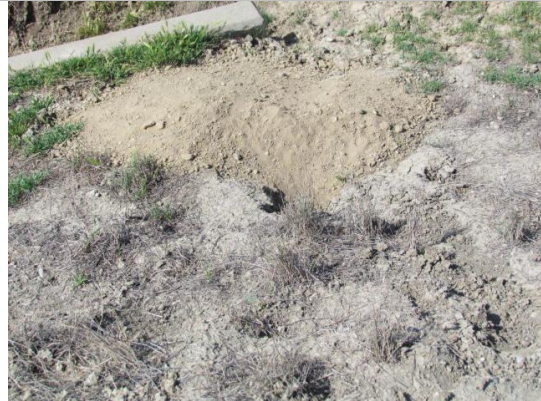
Photo 1 of 1 : FA_2015_NA0010_126_7_20150914_00005.jpg

LM Start	2.07	Rating **	M	Issue No.	7
LM End	2.13	Issue Type +	Ma	Location *	LS
Category	Earthen Levee			GPS Latitude/Longitude	
				Start	End
Item	Animal Control			37.258063 °	37.257688 °
				-120.742460 °	-120.741573 °
DWR ID	DWR_NA0010_08_s_2012_7				
Action/Comments					
Exterminate rodents and backfill and compact or grout burrows. Inspector Comments: No rodent activity and no rodent holes noted.

Looking at typical rodent hole on landside slope near headwall.

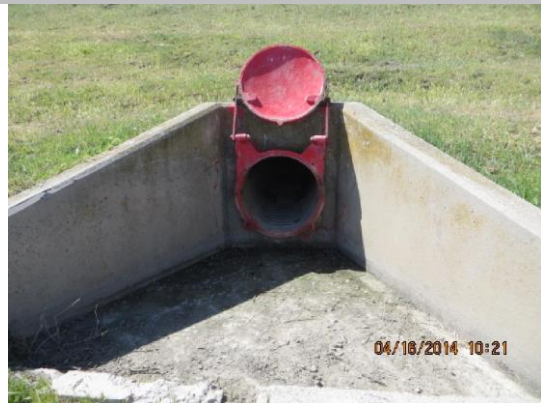
Photo 1 of 3 : UCIP_FA_2015_3968.jpg

Pipe, headwall, and flapgate on WS toe.

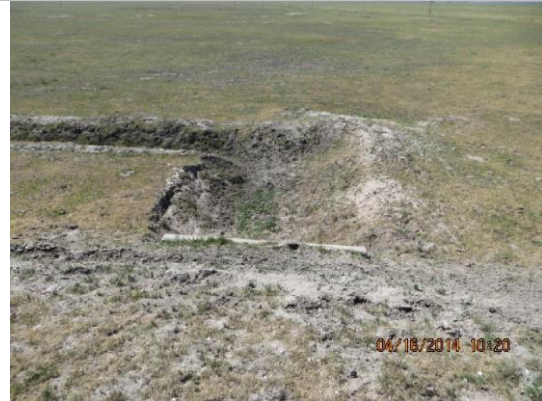
Photo 2 of 3 : UCIP_FA_2015_3969.jpg

Inspector Comments: FS_ID:39512
 DS_ID:19836
 EP_NO: N/A
 FS_HLM: 2.121
 Repair Type: Non-Urgent
 Crossing Status: Found
 UCIP Comments: Sediment buildup in pipe visible from landward side.
 FIELD_STRUCT_DESC: 24-inch CM stormdrain pipe through levee, 9.5-feet below crown. Flap gate on the waterward end. Concrete headwall on both ends. (USACE-1967). This entry matches the Drainage or Irrigation Structure referenced in O&M manual (HLM 2.12).
 FS Date: 04/16/2014

Pipe and headwall on LS toe.

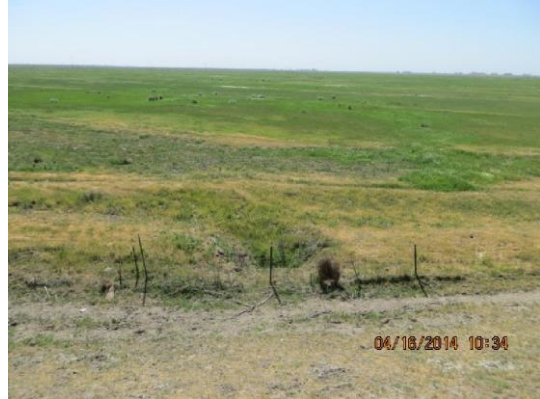
Photo 1 of 3 : UCIP_FA_2015_3971.jpg

LM Start	3.06	Rating **	U	Issue No.	34
LM End	3.06	Issue Type +	En	Location *	LS
Category	Supplemental			GPS Latitude/Longitude	
				Start	End
Item	DWR UCIP Field Study			37.250864 °	37.250864 °
				-120.728151 °	-120.728151 °
DWR ID					
Action/Comments					
Inspector Comments: FS_ID:42853 DS_ID:19838 EP_NO: N/A FS_HLM: 3.06 Repair Type: Urgent Crossing Status: Found

Pipe and headwall on LS toe.
