**Flood Control Project Maintenance
Levee Inspections**

Fall 2015 Levee Maintenance Deficiency Summary Report

San Joaquin River Basin

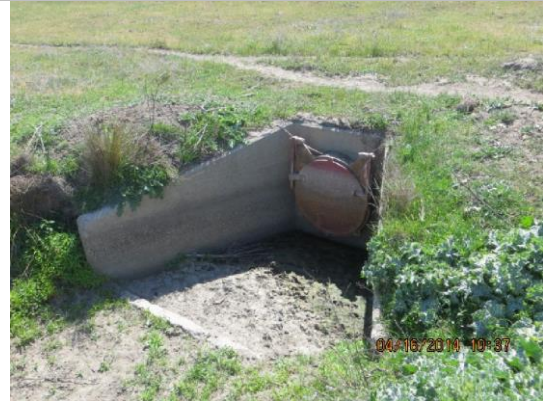
Photo 3 of 3 : UCIP_FA_2015_3997.jpg

Pipe, headwall, and flapgate on WS toe.

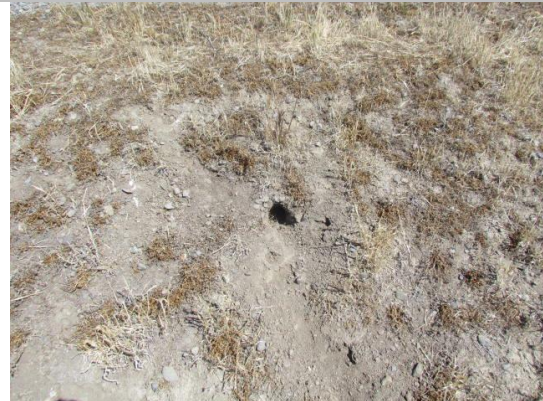
Photo 1 of 1 : FA_2015_NA0010_126_3_20150914_00001.jpg

LM Start	3.40	Rating **	M	Issue No.	3
LM End	3.54	Issue Type +	Ma	Location *	LS
Category	Earthen Levee			GPS Latitude/Longitude	
				Start	End
Item	Animal Control			37.253052 °	37.253600 °
				-120.722647 °	-120.720198 °
DWR ID	DWR_NA0010_08_s_2012_3				
Action/Comments					
No rodents visible, but rodent burrows visible; need to backfill and compact or grout burrows. Inspector Comments: Noted several rodent holes on landward slope within this reach.

Looking at typical view of rodent holes on landward slope.

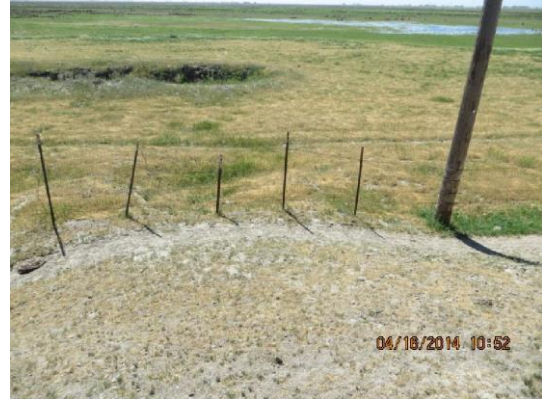
Photo 1 of 3 : UCIP_FA_2015_4000.jpg

Inspector Comments: FS_ID:39513
 DS_ID:19840
 EP_NO: N/A
 FS_HLM: 3.43
 Repair Type: Non-Urgent
 Crossing Status: Found
 UCIP Comments: No access available on landward side. Need to confirm status of crossing.
 FIELD_STRUCT_DESC: 24-inch CM stormdrain pipe through levee, 13.0 feet below crown. Flap gate on the waterward end. Concrete headwall on both ends. (USACE-1967). This entry matches the Drainage or Irrigation Structure referenced in O&M manual (HLM 3.43).
 FS Date: 04/16/2014

Pipe likely at drainage swale off LS toe.

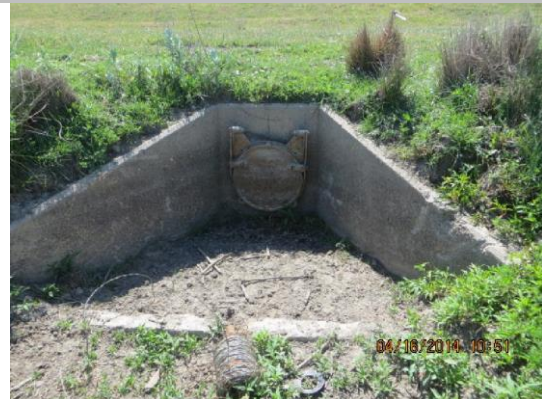
Photo 2 of 3 : UCIP_FA_2015_4001.jpg

Pipe, headwall, and flapgate on WS toe.

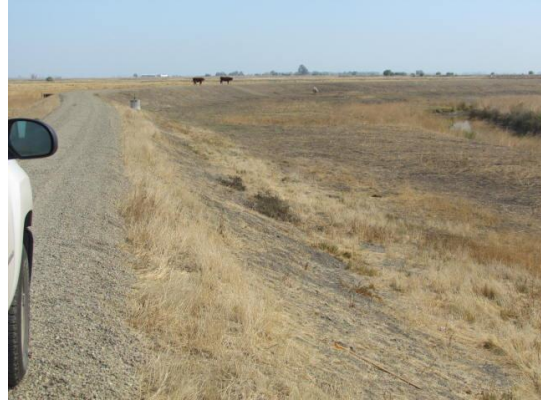
Photo 1 of 1 : FA_2015_NA0010_127_4_20151014_00002.jpg

Looking at typical view of waterward slope.

LM Start	0.00	Rating **	A	Issue No.	4
LM End	0.87	Issue Type +	Ma	Location *	WS
Category	Earthen Levee			GPS Latitude/Longitude	
				Start	End
Item	Vegetation				° 37.220062
					° -120.698278
DWR ID	DWR_NA0010_09_f_2015_4				
Action/Comments					
Remove the wild growth other than native grasses from the levee slopes.

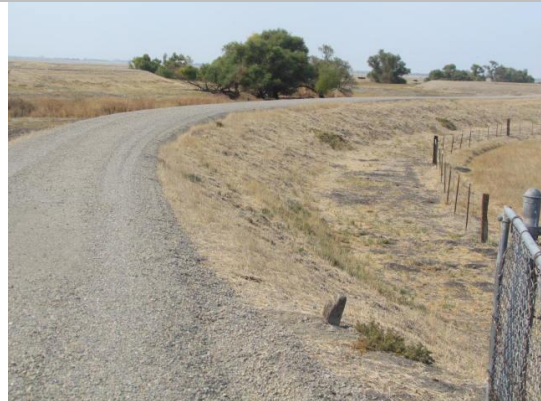
Photo 1 of 1 : FA_2015_NA0010_127_3_20151014_00001.jpg

LM Start	0.00	Rating **	A	Issue No.	3
LM End	0.87	Issue Type +	Ma	Location *	LS
Category	Earthen Levee			GPS Latitude/Longitude	
				Start	End
Item	Vegetation				° 37.220062
					° -120.698277
DWR ID	DWR_NA0010_09_f_2015_3				
Action/Comments					
Remove the wild growth other than native grasses from the levee slopes.

Looking at typical view of landward slope.

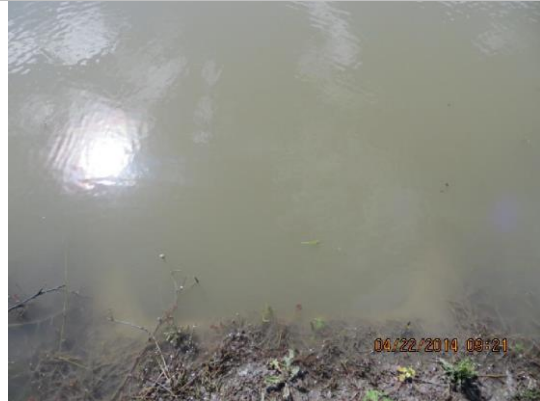
Photo 1 of 3 : UCIP_FA_2015_3616.jpg

Inspector Comments: FS_ID:39888
 DS_ID:19841
 EP_NO: N/A
 FS_HLM: 0.473
 Repair Type: Non-Urgent
 Crossing Status: Found
 UCIP Comments: Concrete headwalls on landward and waterward under water. Need photo to confirm condition of concrete headwalls, pipe, and gate on both toes.
 FIELD_STRUCT_DESC: 24-inch C.M. stormdrain pipe through the levee, 18.7-feet below the crown. Slide gate inside 36-inch C.M. pipe riser on the waterward slope. Concrete "U" headwalls on both ends. (USACE-1967). This entry matches the Drainage or Irrigation Structure referenced in O&M manual (HLM 0.47).
 FS Date: 04/22/2014

Concrete headwall visible under water on WS toe.

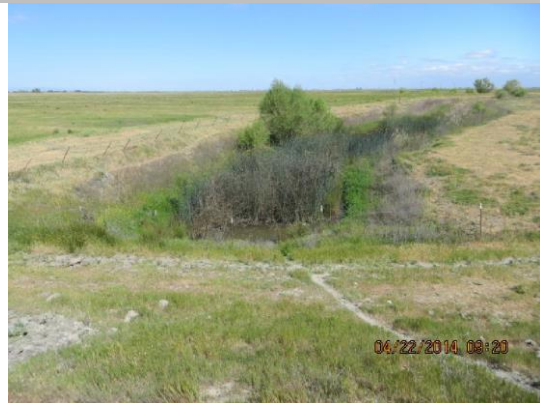
Photo 2 of 3 : UCIP_FA_2015_3617.jpg

Concrete headwall visible at inlet on LS toe.

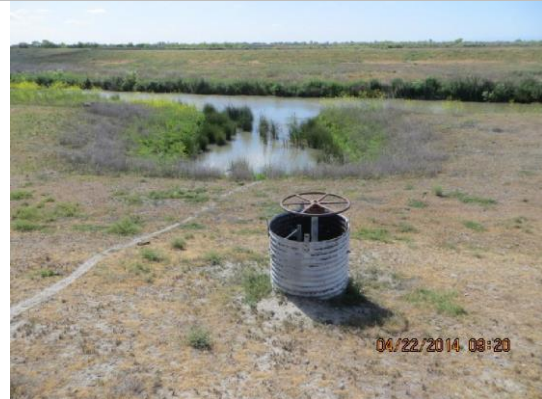
Photo 3 of 3 : UCIP_FA_2015_3618.jpg

Slide gate in CMP riser on WS slope with outlet visible in background.

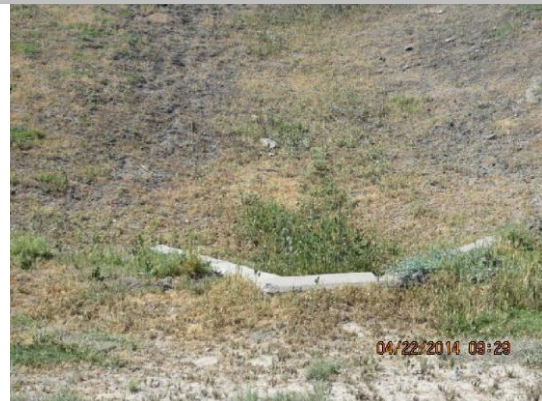
Photo 1 of 3 : UCIP_FA_2015_3793.jpg

Headwall, flapgate, and pipe on WS toe.

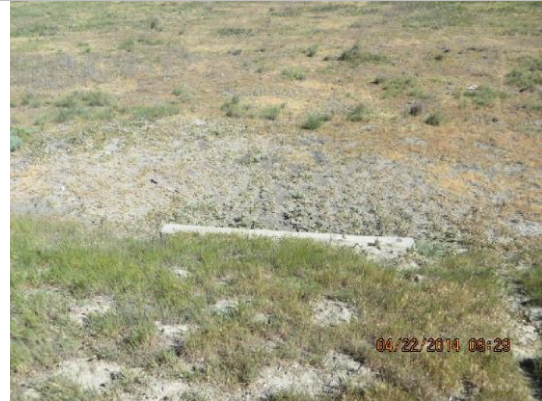
Photo 2 of 3 : UCIP_FA_2015_3794.jpg

Inspector Comments: FS_ID:39515
 DS_ID:19842
 EP_NO: N/A
 FS_HLM: 0.697
 Repair Type: Non-Urgent
 Crossing Status: Found
 UCIP Comments: Animal burrows in area on LS slope. Minor sediment buildup in pipe visible on landward side--recommend clearing.
 FIELD_STRUCT_DESC: 24-inch C.M. stormdrain pipe through the levee, 8.7-feet below the crown. Flap gate on the waterward end. Concrete headwall on the landward end. Concrete "U" headwall on the waterward end. (USACE-1967). This entry matches the Drainage or Irrigation Structure referenced in O&M manual (HLM 0.70).
 FS Date: 04/22/2014

Headwall and pipe on LS toe.

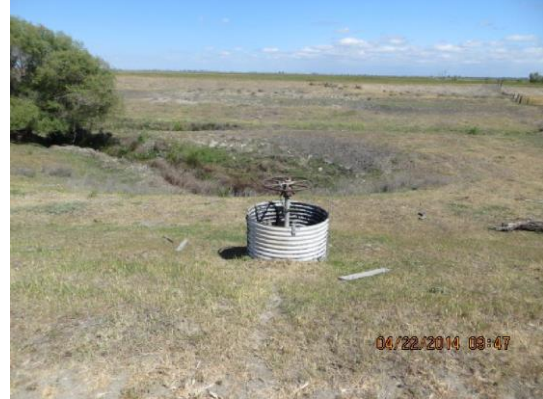
Photo 1 of 3 : UCIP_FA_2015_5466.jpg

Headwall and pipe visible on LS toe. Slide gate inside 48-inch CMP riser on WS slope.

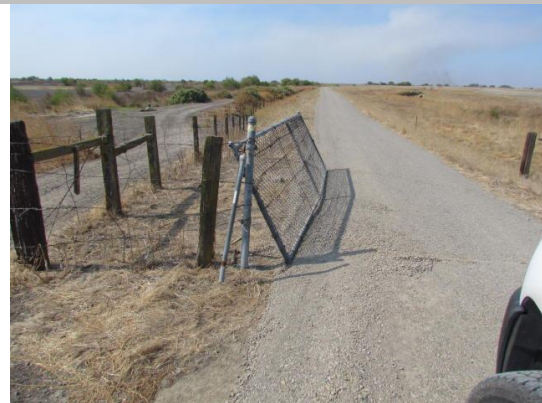
Photo 1 of 1 : FA_2015_NA0010_128_2_20151014_00001.jpg

LM Start	0.79	Rating **	U	Issue No.	2
LM End	0.79	Issue Type +	En	Location *	WS
Category	Earthen Levee			GPS Latitude/Longitude	
				Start	End
Item	Encroachments			37.219336 °	37.219336 °
				-120.698085 °	-120.698085 °
DWR ID	DWR_NA0010_10_f_2015_2				
Action/Comments					
Fence					
Inspector Comments: Repair gate no hingers.

Looking at gate at LM 0.79

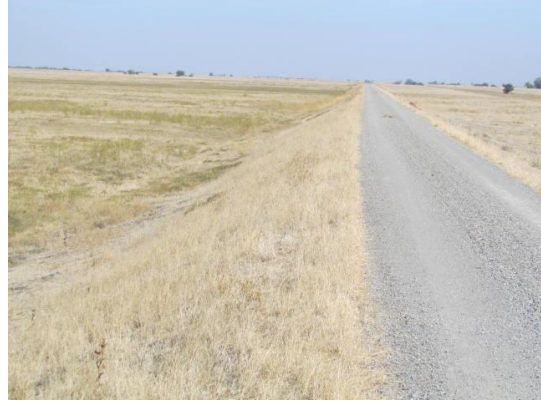
Photo 1 of 1 : FA_2015_NA0010_129_9_20151014_00001.jpg

LM Start	0.00	Rating **	A	Issue No.	9
LM End	3.31	Issue Type +	Ma	Location *	LS
Category	Earthen Levee			GPS Latitude/Longitude	
				Start	End
Item	Vegetation			37.202752 °	37.202314 °
				-120.755180 °	-120.695292 °
DWR ID	DWR_NA0010_11_f _ 2015_9				
Action/Comments					
Remove the wild growth other than native grasses from the levee slopes.

Looking at typical view of landward slope.

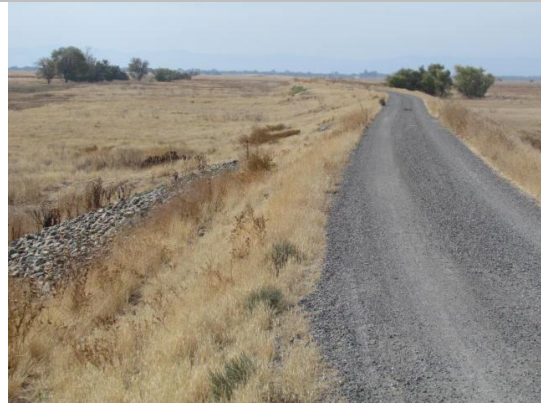
Photo 1 of 1 : FA_2015_NA0010_129_10_20151014_00002.jpg

LM Start	0.00	Rating **	A	Issue No.	10
LM End	3.31	Issue Type +	Ma	Location *	WS
Category	Earthen Levee			GPS Latitude/Longitude	
				Start	End
Item	Vegetation			37.202751 °	37.202314 °
				-120.755179 °	-120.695291 °
DWR ID	DWR_NA0010_11_f_2015_10				
Action/Comments					
Remove the wild growth other than native grasses from the levee slopes.

Looking at typical view of waterward slope.

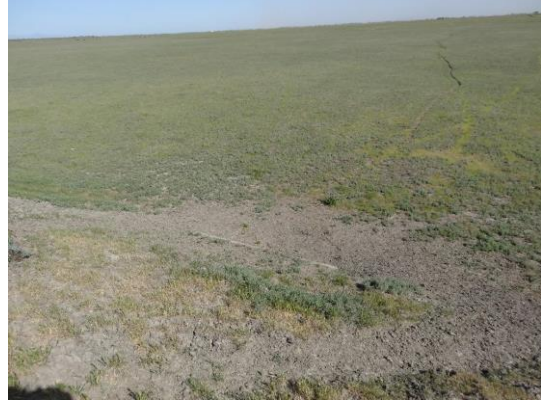
Photo 1 of 3 : UCIP_FA_2015_5744.jpg

Action/Comments					
Inspector Comments: FS_ID:39517 DS_ID:19846 EP_NO: N/A FS_HLM: 0.42 Repair Type: Non-Urgent Crossing Status: Found UCIP Comments: Need to contact owner. Recommend clearing sediment deposit inside pipe. FIELD_STRUCT_DESC: 24-inch C.M. pipe through the levee, 11.0 feet below the crown. Slide gate inside CMP riser located on the waterward end. (USACE-1967). This entry matches the Drainage or Irrigation Structure referenced in O&M manual (HLM 0.42). FS Date: 04/18/2014

View of landward side.

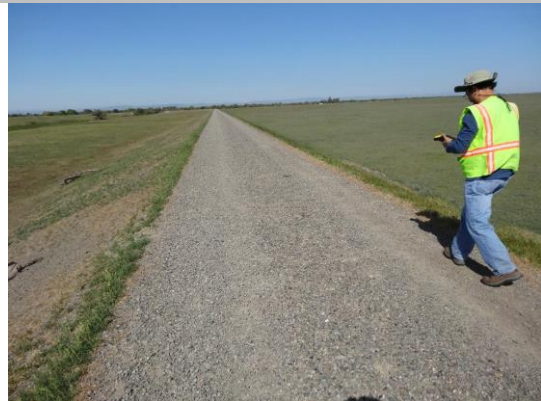
Photo 2 of 3 : UCIP_FA_2015_5745.jpg

View of levee crown at crossing.

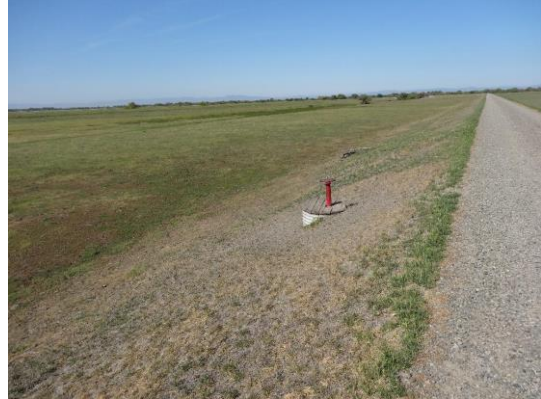
Photo 3 of 3 : UCIP_FA_2015_5746.jpg

View of slide gate inside CMP riser located on waterward slope.

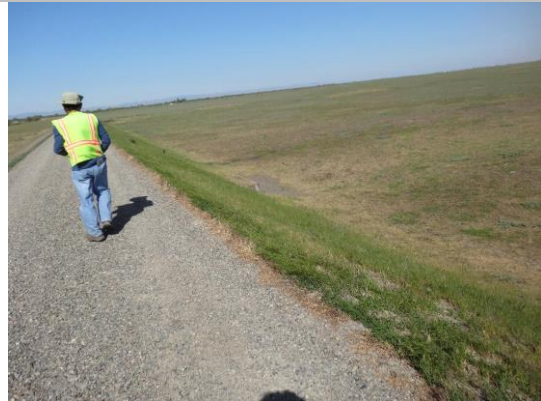
Photo 1 of 3 : UCIP_FA_2015_3648.jpg

View of landward side.

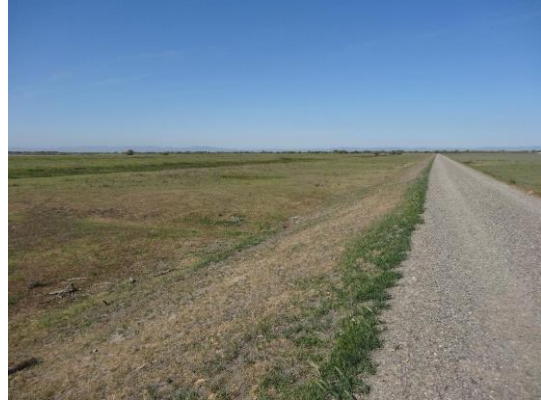
Photo 2 of 3 : UCIP_FA_2015_3649.jpg

Action/Comments					
Inspector Comments: FS_ID:39518 DS_ID:19847 EP_NO: N/A FS_HLM: 0.65 Repair Type: Non-Urgent Crossing Status: Found UCIP Comments: Need to contact owner. Recommend clearing sediment deposit inside pipe. FIELD_STRUCT_DESC: 24-inch C.M. pipe through the levee, 10.0 feet below the crown. Flap gate on the waterward end. (USACE-1967). This entry matches the Drainage or Irrigation Structure referenced in O&M manual (HLM 0.65). FS Date: 04/18/2014

View of waterward side.

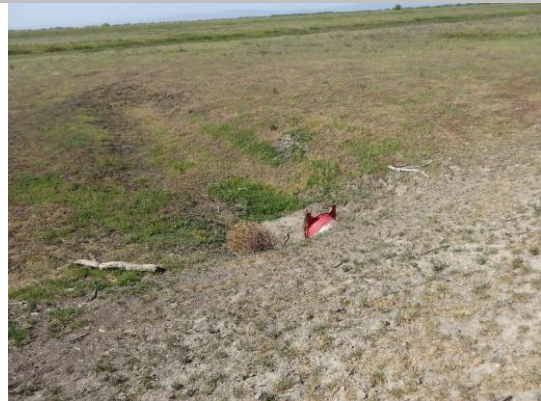
Photo 3 of 3 : UCIP_FA_2015_3650.jpg

Flap gate and concrete apron located on waterward side.

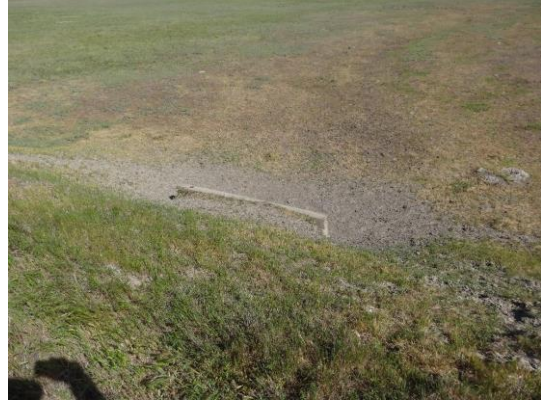
Photo 1 of 3 : UCIP_FA_2015_3651.jpg

View of landward side.

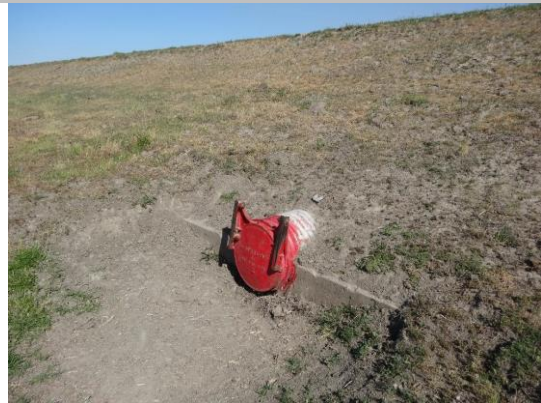
Photo 2 of 3 : UCIP_FA_2015_3652.jpg

Concrete headwall and flap gate visible on waterward side.

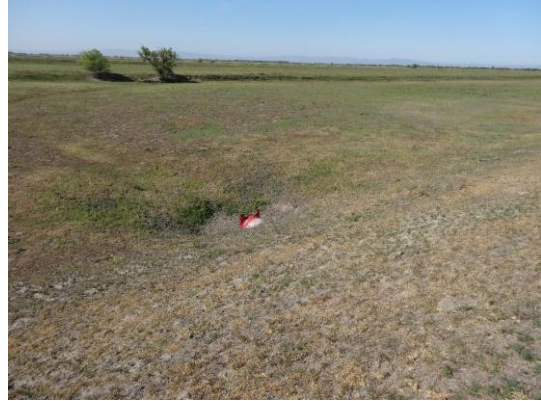
Photo 3 of 3 : UCIP_FA_2015_3653.jpg

Overview of waterward side.

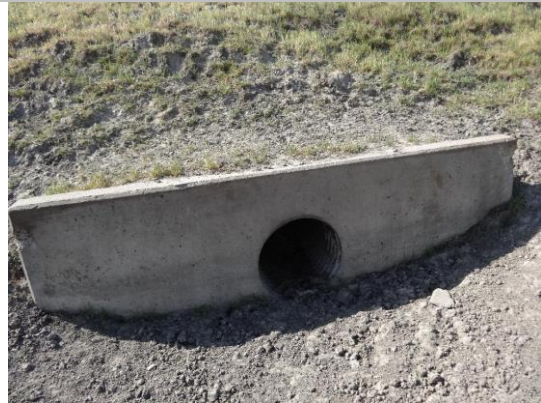
Photo 1 of 3 : UCIP_FA_2015_3685.jpg

Concrete headwall located on landward side.

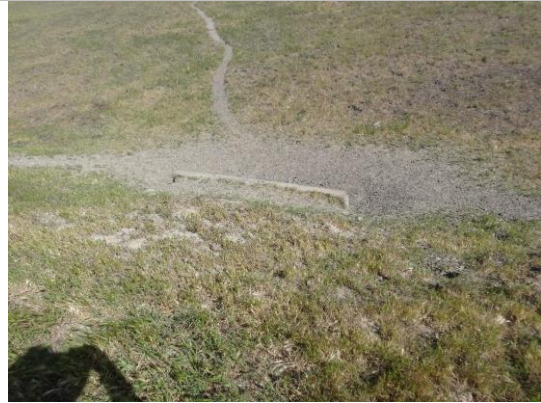
Photo 2 of 3 : UCIP_FA_2015_3686.jpg

Inspector Comments: FS_ID:39520
 DS_ID:19849
 EP_NO: N/A
 FS_HLM: 1.13
 Repair Type: Non-Urgent
 Crossing Status: Found
 UCIP Comments: Need to contact owner. Recommend clearing sediment deposit inside pipe.
 FIELD_STRUCT_DESC: 24-inch C.M. pipe through the levee, 9.0 feet below the crown. Flap gate on the waterward end. (USACE-1967). This entry matches the Drainage or Irrigation Structure referenced in O&M manual (HLM 1.13).
 FS Date: 04/18/2014

View of landward side.

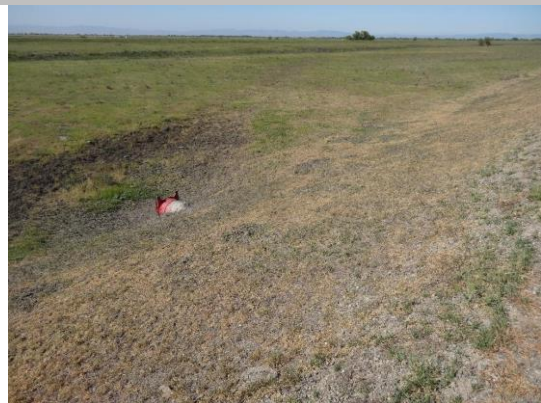
Photo 3 of 3 : UCIP_FA_2015_3687.jpg

View of waterward side--flap gate visible at levee toe.

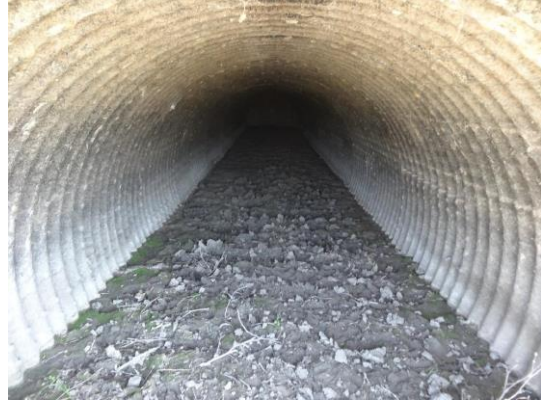
Photo 1 of 3 : UCIP_FA_2015_3688.jpg

Inside view of pipe from waterward side--sediment build up.

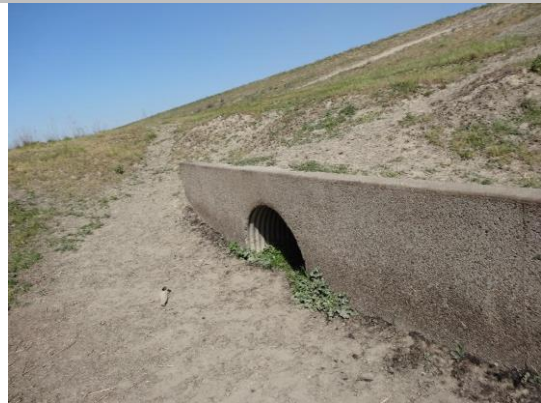
Photo 2 of 3 : UCIP_FA_2015_3689.jpg

View of concrete headwall located on waterward side.

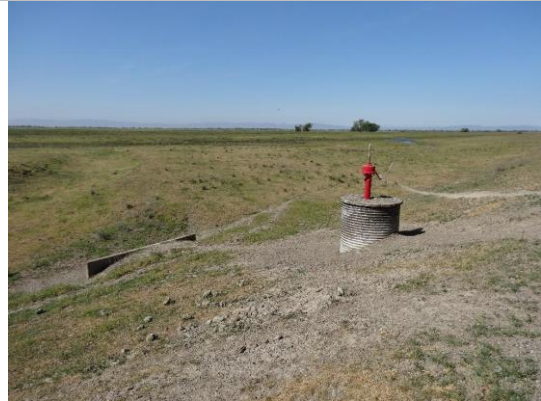
Photo 3 of 3 : UCIP_FA_2015_3690.jpg

View of waterward side.

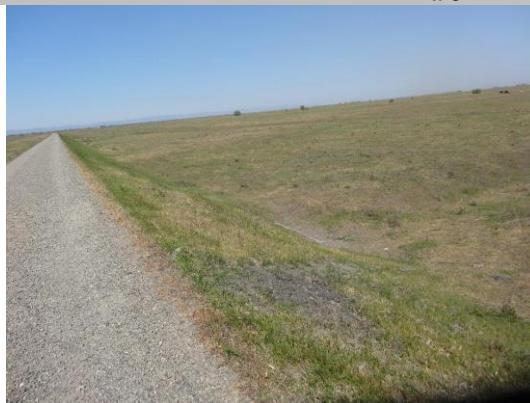
Photo 1 of 3 : UCIP_FA_2015_5581.jpg

Action/Comments					
Inspector Comments: FS_ID:39522 DS_ID:19851 EP_NO: N/A FS_HLM: 1.98 Repair Type: Non-Urgent Crossing Status: Found UCIP Comments: Need to contact owner. Recommend clearing sediment deposit inside pipe. FIELD_STRUCT_DESC: 24-inch C.M. pipe through the levee, 12.8 feet below the crown. Flap gate on the waterward end. (USACE-1967). This entry matches the Drainage or Irrigation Structure referenced in O&M manual (HLM 1.99). FS Date: 04/18/2014

View of landward side.

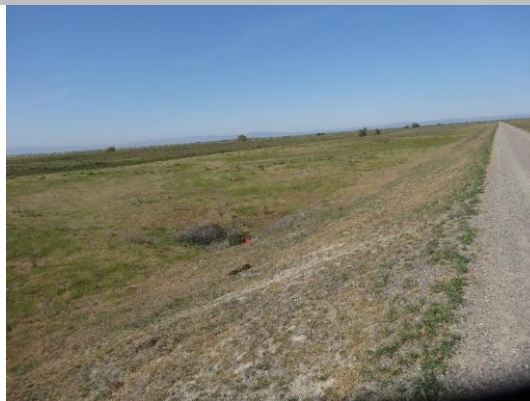
Photo 2 of 3 : UCIP_FA_2015_5582.jpg

View of waterward side.

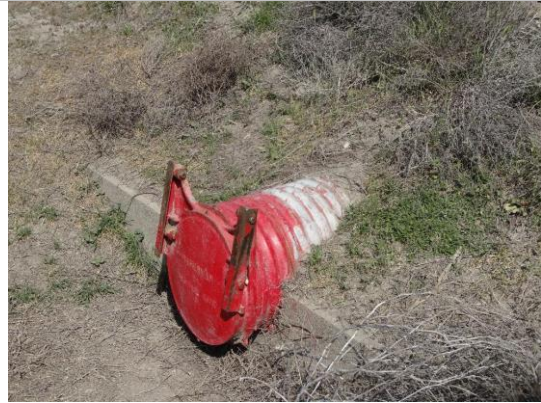
Photo 3 of 3 : UCIP_FA_2015_5583.jpg

LM Start	1.98	Rating **	M	Issue No.	16 (cont)
LM End	1.98	Issue Type +	En	Location *	LS
Category	Supplemental			GPS Latitude/Longitude	
				Start	End
Item	DWR UCIP Field Study			37.202740 °	37.202740 °
				-120.719247 °	-120.719247 °
DWR ID					
Action/Comments					
Inspector Comments: FS_ID:39522 DS_ID:19851 EP_NO: N/A FS_HLM: 1.98 Repair Type: Non-Urgent Crossing Status: Found

Flap gate located on waterward side.

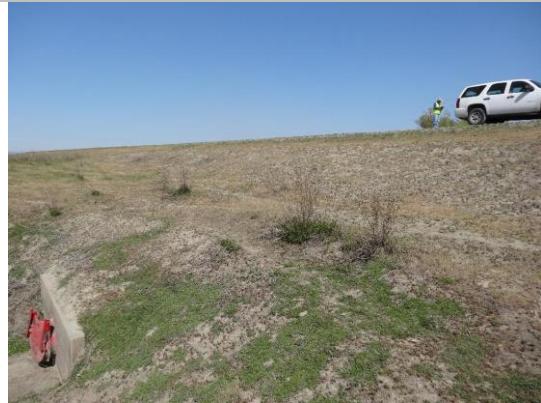
Photo 1 of 3 : UCIP_FA_2015_5480.jpg

LM Start	3.04	Rating **	M	Issue No.	17
LM End	3.04	Issue Type +	En	Location *	LS
Category	Supplemental			GPS Latitude/Longitude	
				Start	End
Item	DWR UCIP Field Study			37.202494 °	37.202494 °
				-120.700153 °	-120.700153 °
DWR ID					
Action/Comments					
Inspector Comments: FS_ID:39523 DS_ID:19852 EP_NO: N/A FS_HLM: 3.04 Repair Type: Non-Urgent Crossing Status: Found UCIP Comments: Need to contact owner. Recommend clearing sediment deposit inside pipe. FIELD_STRUCT_DESC: 24-inch C.M. pipe through the levee, 15.0 feet below the crown. Flap gate on the waterward end. (USACE-1967). This entry matches the Drainage or Irrigation Structure referenced in O&M manual (HLM 3.04). FS Date: 04/18/2014

Overview of waterward side--flap gate, concrete headwall and apron visible on levee toe.

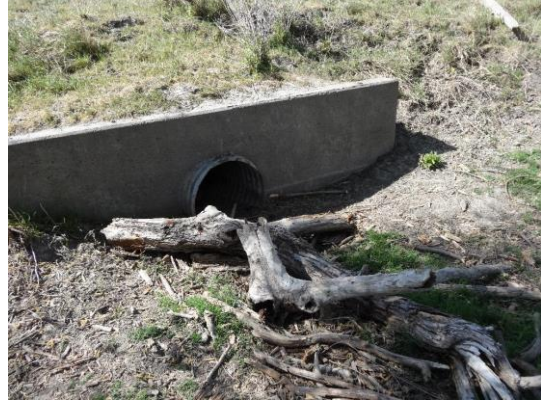
Photo 2 of 3 : UCIP_FA_2015_5481.jpg

Inspector Comments: FS_ID:39523
 DS_ID:19852
 EP_NO: N/A
 FS_HLM: 3.04
 Repair Type: Non-Urgent
 Crossing Status: Found
 UCIP Comments: Need to contact owner. Recommend clearing sediment deposit inside pipe.
 FIELD_STRUCT_DESC: 24-inch C.M. pipe through the levee, 15.0 feet below the crown. Flap gate on the waterward end. (USACE-1967). This entry matches the Drainage or Irrigation Structure referenced in O&M manual (HLM 3.04).
 FS Date: 04/18/2014

Concrete headwall located on landward side--debris in front of headwall.

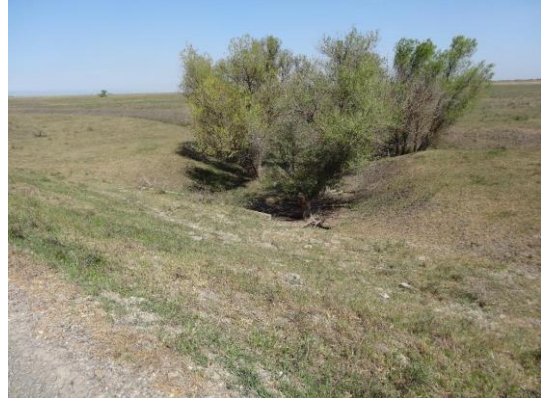
Photo 3 of 3 : UCIP_FA_2015_5584.jpg

View of landward side.

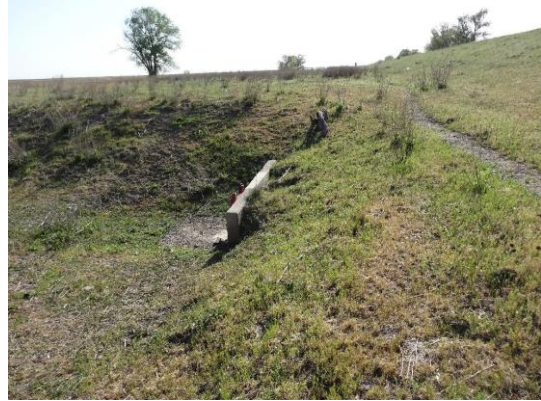
Photo 1 of 3 : UCIP_FA_2015_5594.jpg

Inspector Comments: FS_ID:46786
 DS_ID:19861
 EP_NO: N/A
 FS_HLM: 2.99
 Repair Type: Non-Urgent
 Crossing Status: Found
 UCIP Comments: 11-09-2015 DWR Inspection section confirmed issue has been addressed. Need to coordinate with LMA to determine additional details for extent of repair. 10-18-2014 Soil missing behind concrete headwall on waterward side. Unable to determine if missing soil is due to sink holes, rodent activity, or due to erosion. Headwall appears to be leaning slightly forward. Reason why this crossing was labelled urgent was due to the uncertainty of damage to concrete headwall and reason for soil missing behind concrete. Need to coordinate with LMA to determine more information about repair at this location.
 FIELD_STRUCT_DESC: 24-inch CM pipe through levee, 2 feet below levee crown. Flap gate on the waterward end. (USACE-1967). This entry matches the Drainage or Irrigation Structure referenced in O&M manual (HLM 3.00).

Side view of concrete headwall which appears to be slightly slanted forward--missing soil behind headwall.

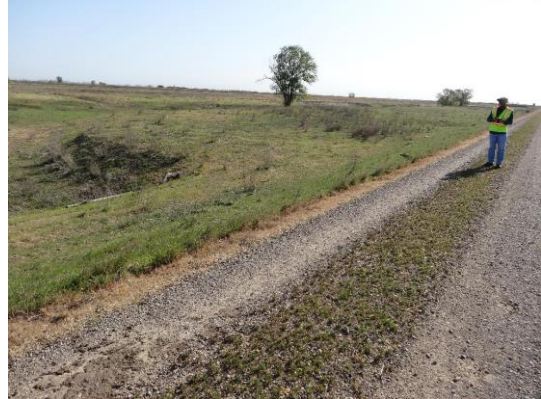
Photo 2 of 3 : UCIP_FA_2015_5595.jpg

View of waterward side.

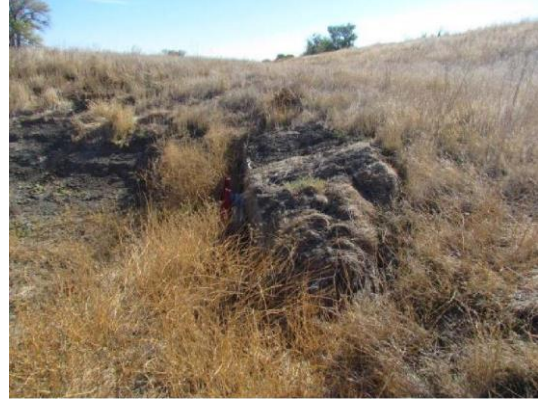
Photo 3 of 3 : UCIP_FA_2015_5896.jpg

Repair to headwall located on waterward side has been addressed.

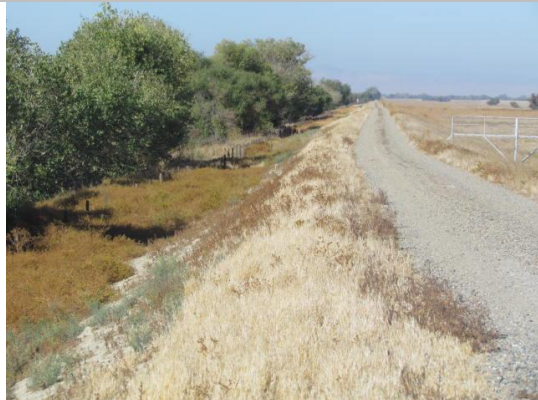
Photo 1 of 1 : FA_2015_NA0010_130_10_20151014_00002.jpg

LM Start	0.00	Rating **	A	Issue No.	10
LM End	3.34	Issue Type +	Ma	Location *	LS
Category	Earthen Levee			GPS Latitude/Longitude	
				Start	End
Item	Vegetation			37.200947 °	37.200969 °
				-120.755164 °	-120.694775 °
DWR ID	DWR_NA0010_12_f_2015_10

Looking at typical view of landward slope.

Remove the wild growth other than native grasses from the levee slopes.

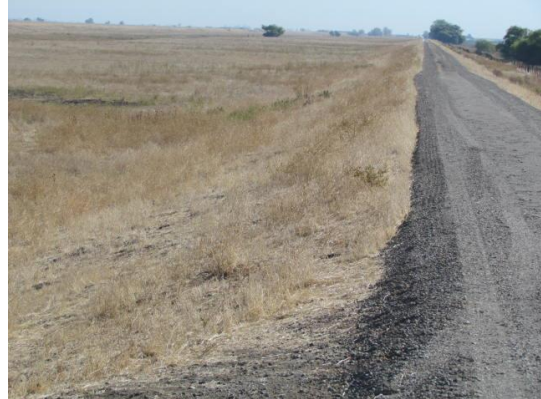
Photo 1 of 1 : FA_2015_NA0010_130_11_20151014_00001.jpg

LM Start	0.00	Rating **	A	Issue No.	11
LM End	3.34	Issue Type +	Ma	Location *	WS
Category	Earthen Levee			GPS Latitude/Longitude	
				Start	End
Item	Vegetation			37.200947 °	37.200969 °
				-120.755164 °	-120.694775 °
DWR ID	DWR_NA0010_12_f _ 2015_11				
Action/Comments					
Remove the wild growth other than native grasses from the levee slopes.

Looking at typical view of waterward slope.

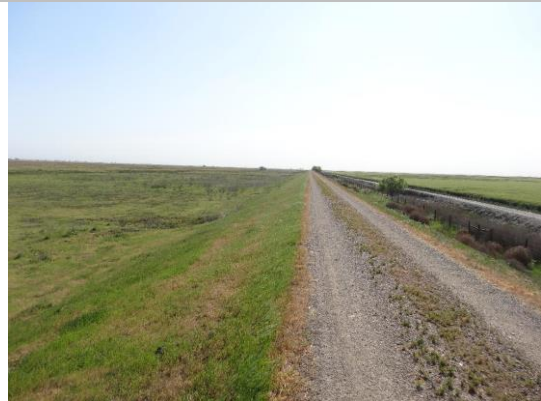
Photo 1 of 3 : UCIP_FA_2015_5747.jpg

LM Start	0.40	Rating **	M	Issue No.	13
LM End	0.40	Issue Type +	En	Location *	WS
Category	Supplemental			GPS Latitude/Longitude	
				Start	End
Item	DWR UCIP Field Study			37.200934 °	37.200934 °
				-120.747996 °	-120.747996 °
DWR ID					
Action/Comments					
Inspector Comments: FS_ID:36704					
DS_ID:19855					
EP_NO: N/A					
FS_HLM: 0.4					
Repair Type: Non-Urgent					
Crossing Status: Found					
UCIP Comments: Need to contact owner. Dense vegetation limits the inspector's visibility to identify signs of pipe failure (leaks) along the waterward slope. Recommend removing vegetation along pipe alignment to conduct proper inspection of structure.					
FIELD_STRUCT_DESC: 24-inch CM pipe through levee, 10.5 feet below crown. Flap gate on the waterward end. (USACE-1967). This entry matches the Drainage or Irrigation Structure referenced in O&M manual (HLM 0.39).					
FS Date: 04/18/2014

View of waterward side.

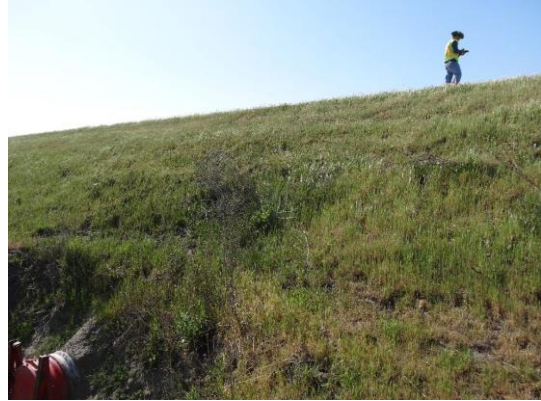
Photo 2 of 3 : UCIP_FA_2015_5748.jpg

Inspector Comments: FS_ID:36704
 DS_ID:19855
 EP_NO: N/A
 FS_HLM: 0.4
 Repair Type: Non-Urgent
 Crossing Status: Found
 UCIP Comments: Need to contact owner. Dense vegetation limits the inspector's visibility to identify signs of pipe failure (leaks) along the waterward slope. Recommend removing vegetation along pipe alignment to conduct proper inspection of structure.
 FIELD_STRUCT_DESC: 24-inch CM pipe through levee, 10.5 feet below crown. Flap gate on the waterward end. (USACE-1967). This entry matches the Drainage or Irrigation Structure referenced in O&M manual (HLM 0.39).
 FS Date: 04/18/2014

View of waterward side--medium grass throughout slope.

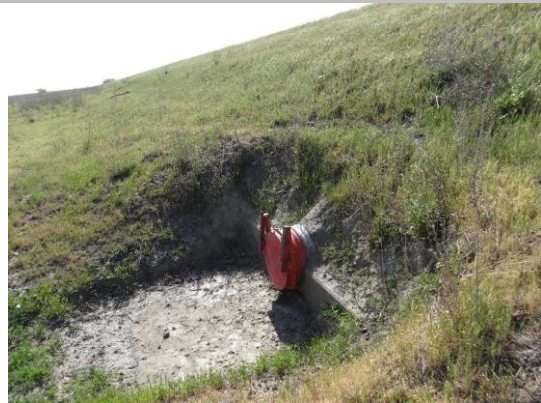
Photo 3 of 3 : UCIP_FA_2015_5749.jpg

Concrete headwall and flap gate visible on waterward side.

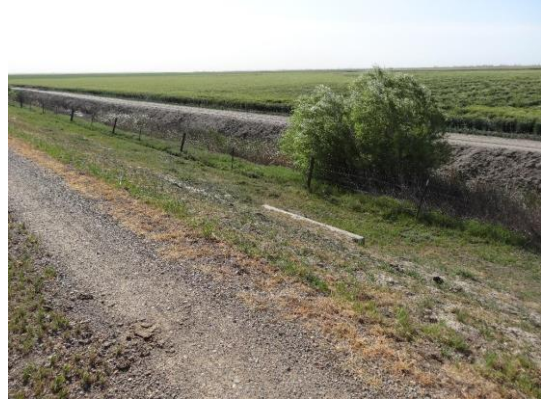
Photo 1 of 3 : UCIP_FA_2015_5482.jpg

View of landward side.

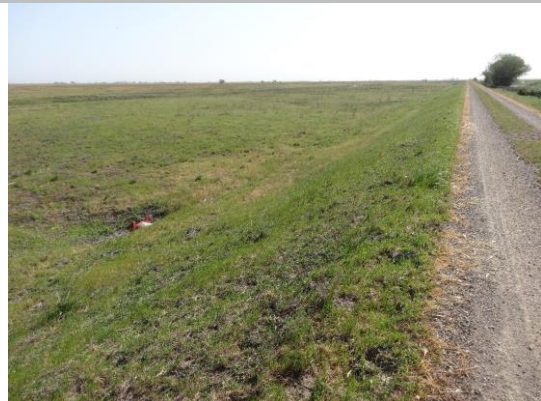
Photo 2 of 3 : UCIP_FA_2015_5483.jpg

View of waterward side.

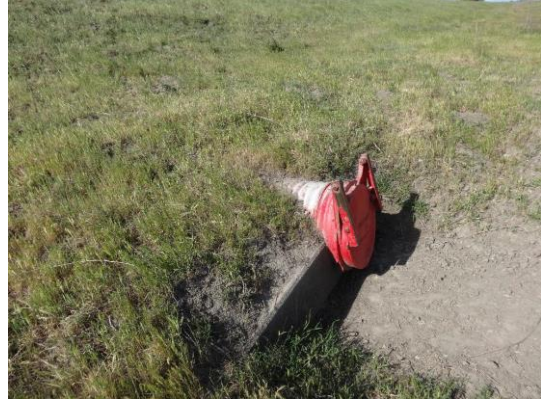
Photo 3 of 3 : UCIP_FA_2015_5484.jpg

Concrete headwall and flap gate visible on waterward side.

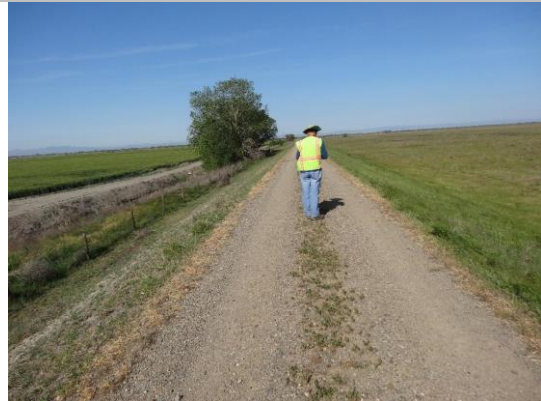
Photo 1 of 3 : UCIP_FA_2015_3149.jpg

LM Start	1.27	Rating **	M	Issue No.	15
LM End	1.27	Issue Type +	En	Location *	WS
Category	Supplemental			GPS Latitude/Longitude	
				Start	End
Item	DWR UCIP Field Study			37.200919 °	37.200919 °
				-120.732234 °	-120.732234 °
DWR ID					
Action/Comments					
Inspector Comments: FS_ID:36705 DS_ID:19857 EP_NO: N/A FS_HLM: 1.271 Repair Type: Non-Urgent Crossing Status: Found UCIP Comments: Landward side not accessible due to dense vegetation and fence. Concrete headwall and flap gate under water therefore not able to evaluate condition. Will need to coordinate with owner to evaluate condition of crossing on waterward side and obtain access to evaluate landward side. FIELD_STRUCT_DESC: 24-inch CM pipe through levee, 17.4 feet below crown. Flap gate on the waterward end. (USACE-1967). This entry matches the Drainage or Irrigation Structure referenced in O&M manual (HLM 1.27). FS Date: 04/18/2014

Overview of levee crown at crossing.

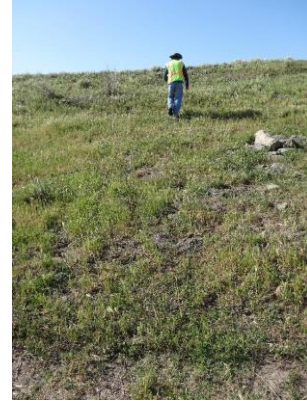
Photo 2 of 3 : UCIP_FA_2015_5750.jpg

View of waterward slope.

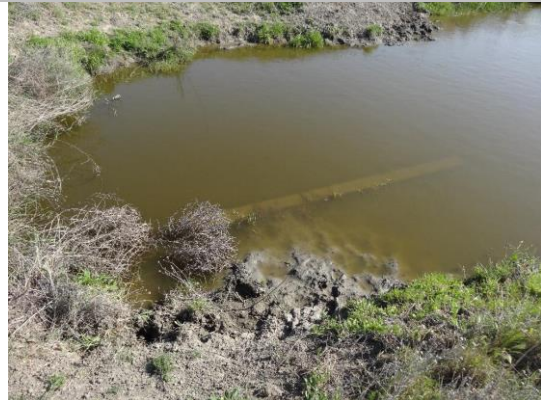
Photo 3 of 3 : UCIP_FA_2015_5751.jpg

View of concrete wall underwater.

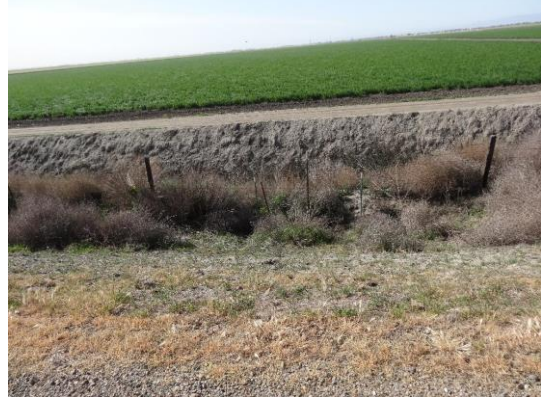
Photo 1 of 3 : UCIP_FA_2015_5585.jpg

View of landward side--limited access due to fence.

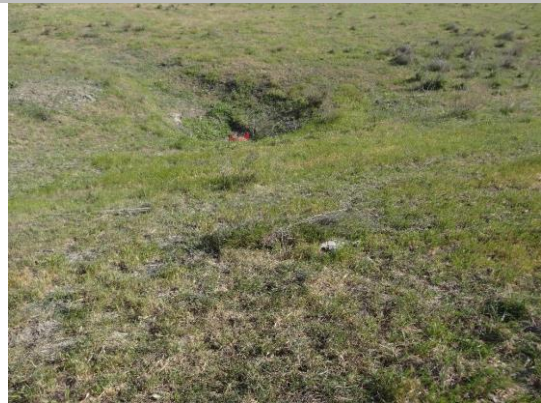
Photo 2 of 3 : UCIP_FA_2015_5586.jpg

View of waterward side.

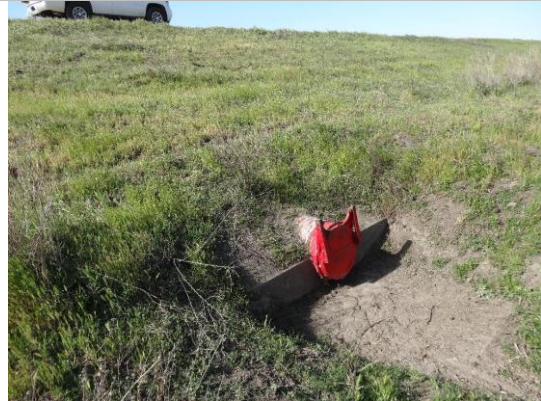
Photo 3 of 3 : UCIP_FA_2015_5587.jpg

Concrete headwall and flap gate visible on waterward side.

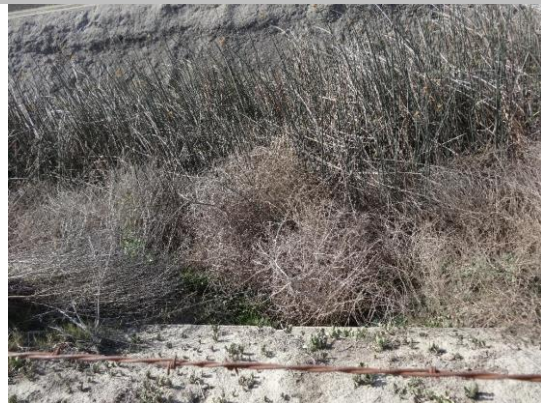
Photo 1 of 3 : UCIP_FA_2015_5588.jpg

LM Start	2.16	Rating **	M	Issue No.	17
LM End	2.16	Issue Type +	En	Location *	WS
Category	Supplemental			GPS Latitude/Longitude	
				Start	End
Item	DWR UCIP Field Study			37.200908 °	37.200908 °
				-120.716118 °	-120.716118 °
DWR ID					
Action/Comments					
Inspector Comments: FS_ID:39506					
DS_ID:19859					
EP_NO: N/A					
FS_HLM: 2.16					
Repair Type: Non-Urgent					
Crossing Status: Found					
UCIP Comments: Need to contact owner. Recommend clearing vegetation from landward side--headwall blocked.					
FIELD_STRUCT_DESC: 24-inch CM pipe through levee, 14.4 feet below crown. Flap gate on the waterward end. (USACE-1967). This entry matches the Drainage or Irrigation Structure referenced in O&M manual (HLM 2.16).					
FS Date: 04/18/2014

Dense vegetation on landward side--limited access due to fence along landward side.

Action/Comments					
Inspector Comments: FS_ID:39506 DS_ID:19859 EP_NO: N/A FS_HLM: 2.16 Repair Type: Non-Urgent Crossing Status: Found UCIP Comments: Need to contact owner. Recommend clearing vegetation from landward side--headwall blocked. FIELD_STRUCT_DESC: 24-inch CM pipe through levee, 14.4 feet below crown. Flap gate on the waterward end. (USACE-1967). This entry matches the Drainage or Irrigation Structure referenced in O&M manual (HLM 2.16). FS Date: 04/18/2014

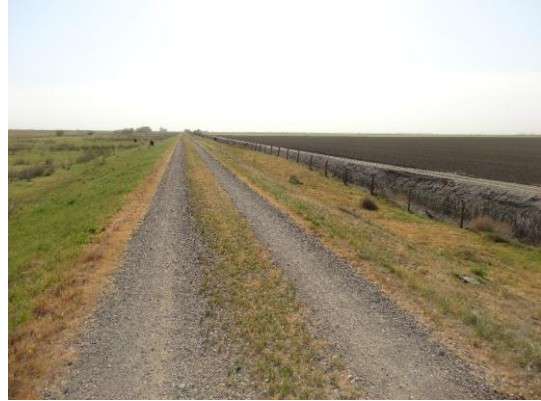
Photo 2 of 3 : UCIP_FA_2015_5589.jpg

Overview of levee crown at crossing.

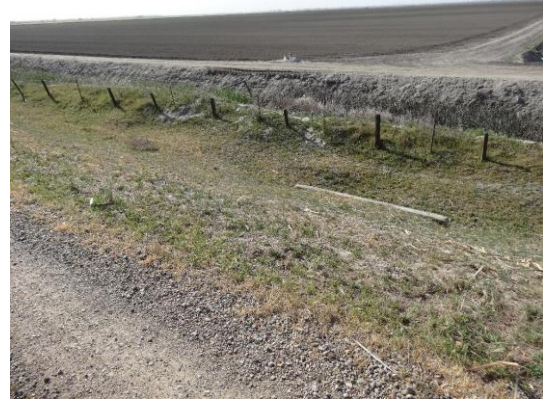
Photo 1 of 3 : UCIP_FA_2015_5591.jpg

LM Start	2.70	Rating **	M	Issue No.	18
LM End	2.70	Issue Type +	En	Location *	LS
Category	Supplemental			GPS Latitude/Longitude	
				Start	End
Item	DWR UCIP Field Study			37.200906 °	37.200906 °
				-120.706316 °	-120.706316 °
DWR ID					
Action/Comments					
Inspector Comments: FS_ID:39890 DS_ID:19860 EP_NO: N/A FS_HLM: 2.7 Repair Type: Non-Urgent Crossing Status: Found UCIP Comments: Need to contact owner. Recommend clearing sediment deposit inside pipe. FIELD_STRUCT_DESC: 24-inch CM pipe through levee, 10.7 feet below crown. Flap gate on the waterward end. (USACE-1967). This entry matches the Drainage or Irrigation Structure referenced in O&M manual (HLM 2.70). FS Date: 04/18/2014

View of landward side.

Inspector Comments: FS_ID:39890
 DS_ID:19860
 EP_NO: N/A
 FS_HLM: 2.7
 Repair Type: Non-Urgent
 Crossing Status: Found
 UCIP Comments: Need to contact owner. Recommend clearing sediment deposit inside pipe.
 FIELD_STRUCT_DESC: 24-inch CM pipe through levee, 10.7 feet below crown. Flap gate on the waterward end. (USACE-1967). This entry matches the Drainage or Irrigation Structure referenced in O&M manual (HLM 2.70).
 FS Date: 04/18/2014

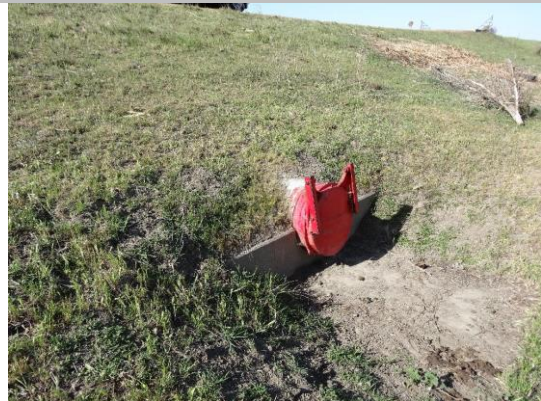
Photo 3 of 3 : UCIP_FA_2015_5593.jpg

Concrete headwall and flat gate located on waterward side.

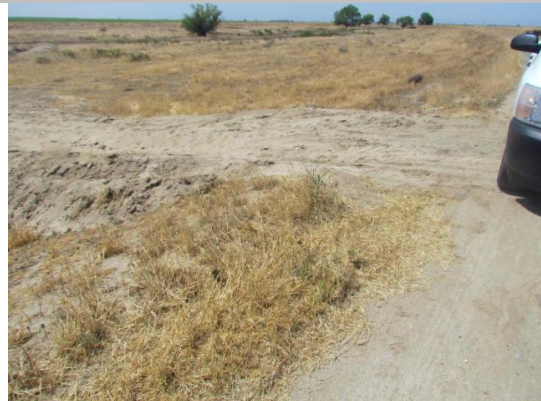
Photo 2 of 3 : FA_2015_NA0010_131_5_20150914_00002.jpg

LM Start	0.91	Rating **	M	Issue No.	5 (cont)	
LM End	0.91	Issue Type +	En	Location *	WS	
Category	Earthen Levee			GPS Latitude/Longitude		
				Start		End
Item	Encroachments			37.044855 °		37.044855
				-120.434106 °		-120.434106
DWR ID	DWR_NA0010_13_s_2014_5					
Action/Comments						
Ramp						
Inspector Comments: Unauthorized ramp on waterward slope.

Looking west at unauthorized ramp on waterward slope.

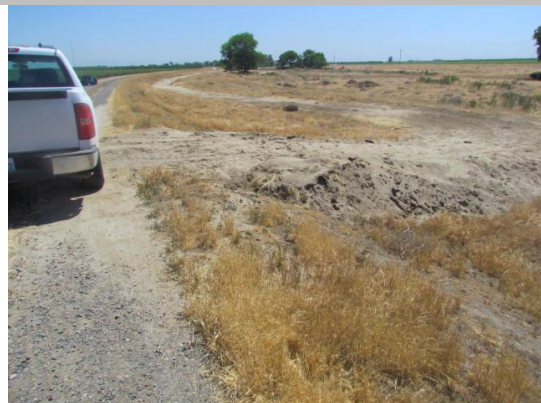
Photo 3 of 3 : FA_2015_NA0010_131_5_20150914_00003.jpg

Looking east at unauthorized ramp on waterward slope.

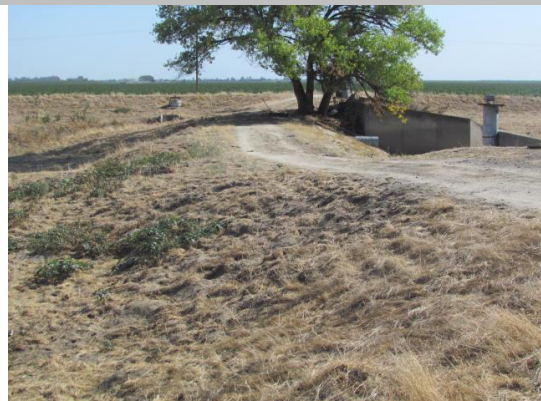
Photo 1 of 5 : FA_2015_NA0010_131_6_20151014_00006.jpg

LM Start	1.14	Rating **	U	Issue No.	6
LM End	1.14	Issue Type +	En	Location *	WS
Category	Earthen Levee			GPS Latitude/Longitude	
				Start	End
Item	Encroachments			37.045541 °	37.045541 °
				-120.430014 °	-120.430014 °
DWR ID	DWR_NA0010_13_f_2015_6				
Action/Comments					
Wall					
Inspector Comments: Landowner built sand dam on upstream side of drop structure.

Looking south at sand dam on upstream side of structure.

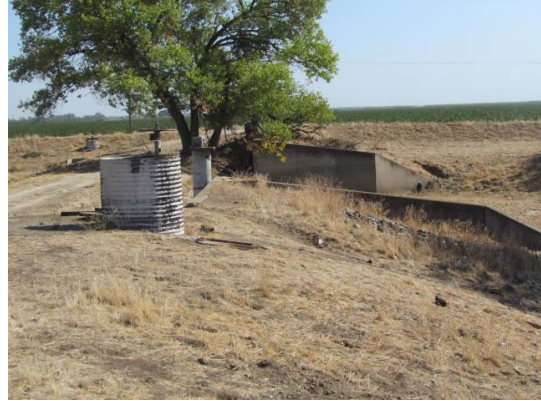
Photo 2 of 5 : FA_2015_NA0010_131_6_20151014_00009.jpg

Looking south at downstream side of structure.

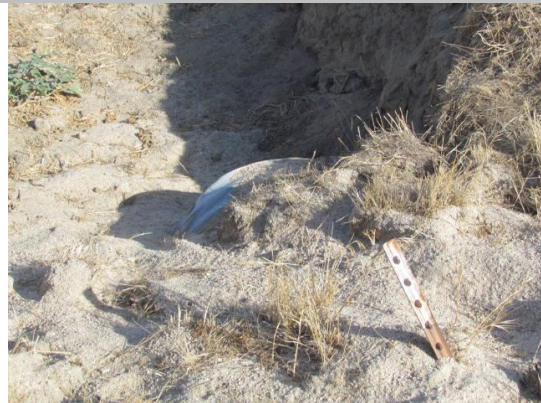
Photo 3 of 5 : FA_2015_NA0010_131_6_20151014_00010.jpg

Looking at corrugated pipe on north end on upstream side of structure.

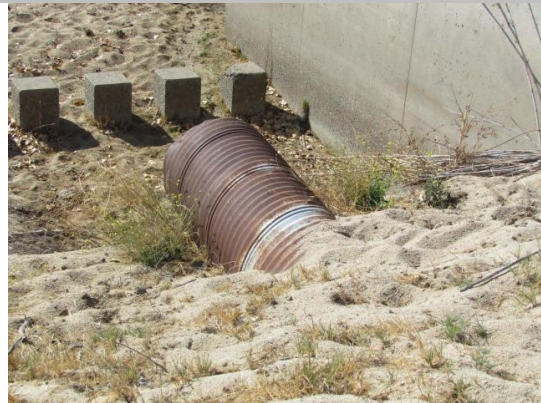
Photo 4 of 5 : FA_2015_NA0010_131_6_20151014_00011.jpg

Looking at corrugated pipe on north end on downstream side of structure.

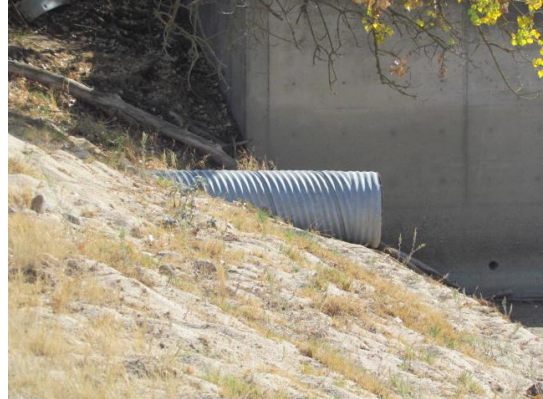
Photo 5 of 5 : FA_2015_NA0010_131_6_20151014_00012.jpg

LM Start	1.14	Rating **	U	Issue No.	6 (cont)	
LM End	1.14	Issue Type +	En	Location *	WS	
Category	Earthen Levee			GPS Latitude/Longitude		
				Start		End
Item	Encroachments			37.045541 °		37.045541 °
				-120.430014 °		-120.430014 °
DWR ID	DWR_NA0010_13_f _ 2015_6					
Action/Comments						
Wall						
Inspector Comments: Landowner built sand dam on upstream side of drop structure.

Looking at corrugated pipe on south end on downstream side of structure.

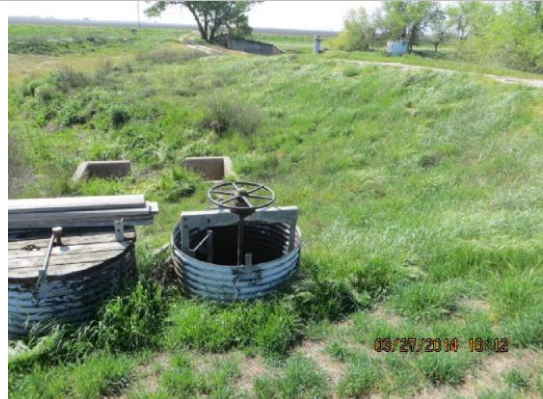
Photo 1 of 3 : UCIP_FA_2015_4292.jpg

Slide gate in CMP riser without at lid on WS shoulder.

Inspector Comments: FS_ID:39524
 DS_ID:19908
 EP_NO: N/A
 FS_HLM: 1.147
 Repair Type: Non-Urgent
 Crossing Status: Found
 UCIP Comments: No lid on riser at WS shoulder could be safety issue.
 FIELD_STRUCT_DESC: 2 of 2: 36-inch C.M. stormdrain pipe through the levee, 12.3 feet below the crown. Slide gate inside 48-inch C.M. pipe riser in waterward slope. Concrete distribution box (6x12-foot) on landward side. 7'X14' concrete distribution box on WS toe (USACE-1967). This entry matches the Drainage or Irrigation Structure referenced in O&M manual (HLM 1.14).
 FS Date: 03/27/2014

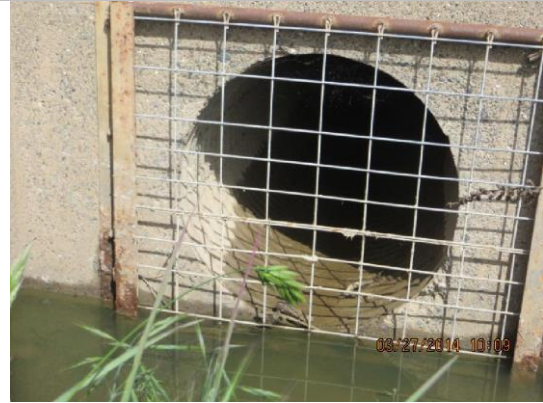
Photo 2 of 3 : UCIP_FA_2015_4293.jpg

Pipe at outlet on WS toe.

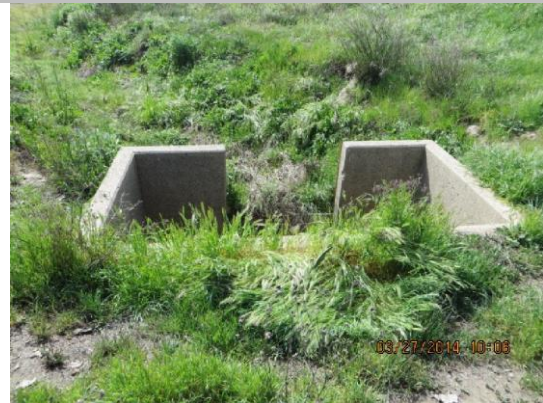
Photo 3 of 3 : UCIP_FA_2015_4294.jpg

Concrete distribution box on WS toe.

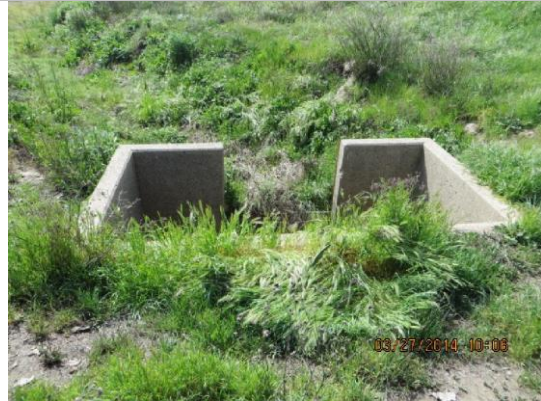
Photo 1 of 3 : UCIP_FA_2015_4289.jpg

Concrete box on WS toe.

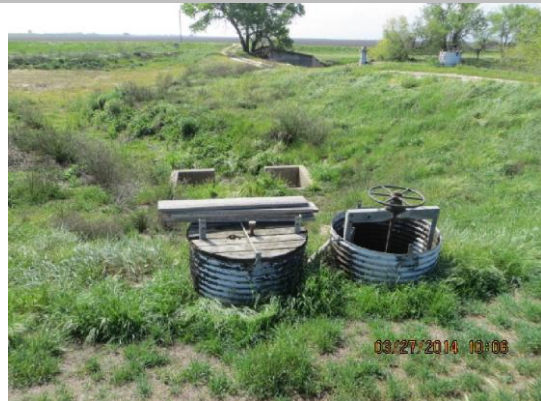
Photo 2 of 3 : UCIP_FA_2015_4290.jpg

Slide gate in CMP riser on WS shoulder.

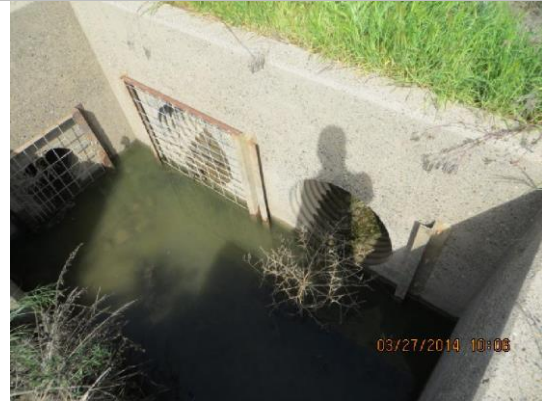
Photo 3 of 3 : UCIP_FA_2015_4291.jpg

Concrete box on WS toe.

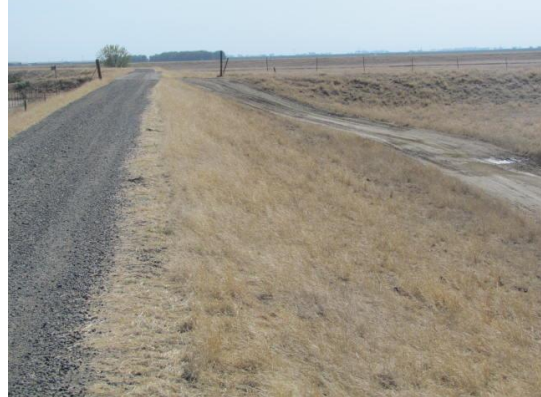
Photo 1 of 1 : FA_2015_NA0010_132_3_20151014_00003.jpg

Looking at typical view of waterward slope.

LM Start	0.00	Rating **	A	Issue No.	3	
LM End	1.28	Issue Type +	Ma	Location *	WS	
Category	Earthen Levee			GPS Latitude/Longitude		
				Start		End
Item	Vegetation				o	
					o	
DWR ID	DWR_NA0010_14_f_2015_3					
Action/Comments						
Remove the wild growth other than native grasses from the levee slopes.

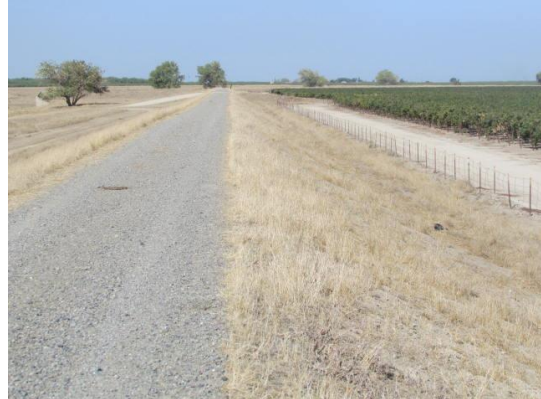
Photo 1 of 2 : FA_2015_NA0010_132_77_20151014_00004.jpg

Looking at typical view of landward slope. Fall 2015

LM Start	0.00	Rating **	A	Issue No.	77
LM End	1.26	Issue Type +	Ma	Location *	LS
Category	Earthen Levee			GPS Latitude/Longitude	
				Start	End
Item	Vegetation			37.032377 °	37.045398 °
				-120.441273 °	-120.427757 °
DWR ID	DWR_NA0010_14_s_2015_77				
Action/Comments					
Remove the wild growth other than native grasses from the levee slopes.					
Inspector Comments: Control growth on landward slope.

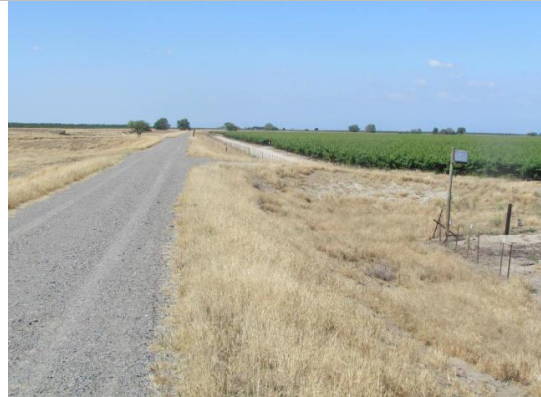
Photo 2 of 2 : FA_2015_NA0010_132_77_20150914_00001.jpg

Looking at typical view of growth on landward slope. Spring 2015

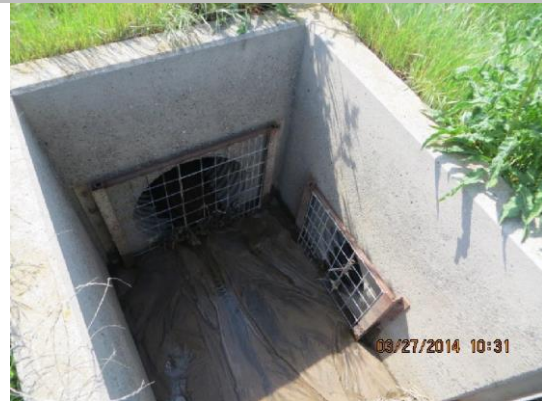
Photo 1 of 3 : UCIP_FA_2015_4295.jpg

concrete inlet/outlet at WS toe.
