**Flood Control Project Maintenance
Levee Inspections**

Fall 2015 Levee Maintenance Deficiency Summary Report

San Joaquin River Basin

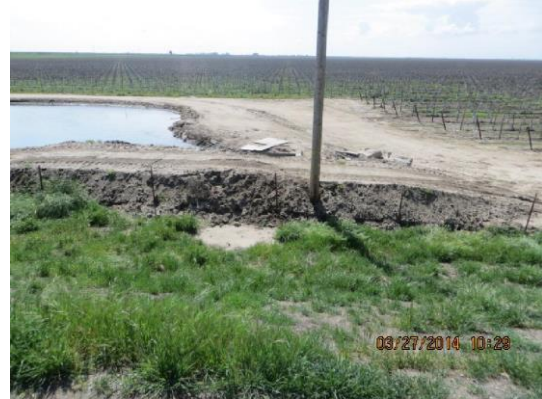
Photo 2 of 3 : UCIP_FA_2015_4296.jpg

Inspector Comments: FS_ID:39526
 DS_ID:19909
 EP_NO: N/A
 FS_HLM: 1.14
 Repair Type: Non-Urgent
 Crossing Status: Found
 UCIP Comments: Lid should be installed on CMP riser on WS slope, could be a safety hazard. Also dense vegetation limits the inspector's visibility to identify signs of pipe failure (leaks) along the slope. Recommend removing vegetation along pipe alignment to conduct proper inspection of structure.
 FIELD_STRUCT_DESC: 36-inch CM pipe through levee, 10-feet below crown. Slide gate inside 48-inch CM pipe riser in waterward slope. Concrete distribution box (6'X7') at toe of waterward slope. Slots for wooden flashboard on waterward side of box. 7'X9' Concrete distribution box on the landward side 20-feet from toe. (USACE-1967). This entry matches the Drainage or Irrigation Structure referenced in O&M manual (HLM 1.15).
 FS Date: 03/27/2014

Concrete distribution box visible next to power pole off LS toe.

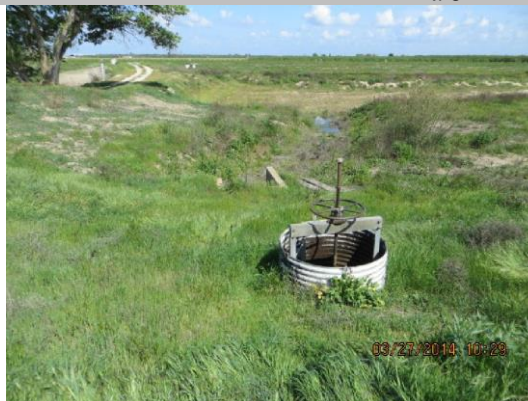
Photo 3 of 3 : UCIP_FA_2015_4297.jpg

Inspector Comments: FS_ID:39526
DS_ID:19909
EP_NO: N/A
FS_HLM: 1.14
Repair Type: Non-Urgent
Crossing Status: Found
UCIP Comments: Lid should be installed on CMP riser on WS slope, could be a safety hazard. Also dense vegetation limits the inspector's visibility to identify signs of pipe failure (leaks) along the slope. Recommend removing vegetation along pipe alignment to conduct proper inspection of structure.
FIELD_STRUCT_DESC: 36-inch CM pipe through levee, 10-feet below crown. Slide gate inside 48-inch CM pipe riser in waterward slope. Concrete distribution box (6'X7') at toe of waterward slope. Slots for wooden flashboard on waterward side of box. 7'X9' Concrete distribution box on the landward side 20-feet from toe. (USACE-1967). This entry matches the Drainage or Irrigation Structure referenced in O&M manual (HLM 1.15).
FS Date: 03/27/2014

Slide gate in CMP riser and outlet/inlet structure visible in background at WS toe.

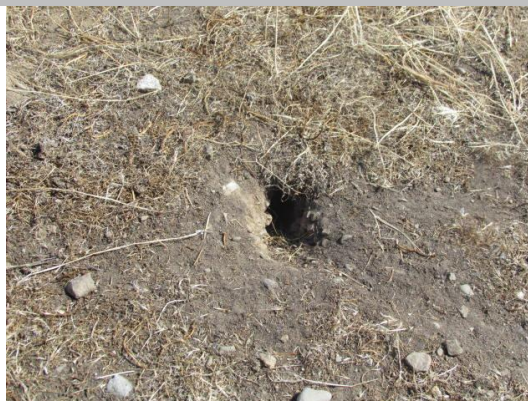
Photo 1 of 1 : FA_2015_NA0010_132_79_20150914_00002.jpg

Looking at typical view of rodent holes on landward slope.

No rodents visible, but rodent burrows visible; need to backfill and compact or grout burrows.
Inspector Comments: Noted several rodent holes on landward at this location.

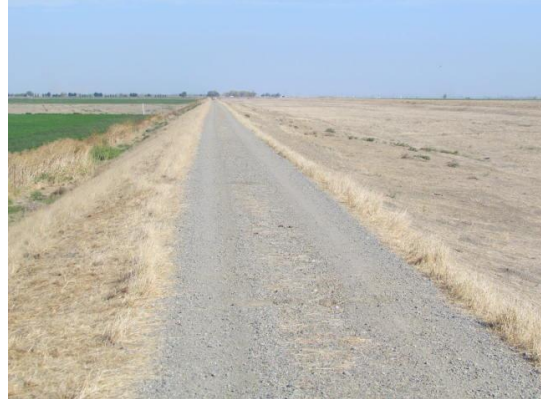
Photo 1 of 2 : FA_2015_NA0010_133_11_20151014_00003.jpg

Looking east at typical view of levee in compliance with standards. Fall 2015

LM Start	0.01	Rating **	A/W	Issue No.	11
LM End	1.99	Issue Type +	Ma	Location *	CR
Category	Earthen Levee			GPS Latitude/Longitude	
				Start	End
Item	Crown Surface / Depressions / Rutting			36.996547 °	36.996587 °
				-120.410220 °	-120.374503 °
DWR ID	DWR_NA0010_15_s_2012_11				
Action/Comments					
Add appropriate material and re-grade the levee to bring the crown above the design elevation.					
Inspector Comments: Control vegetation on levee crown.

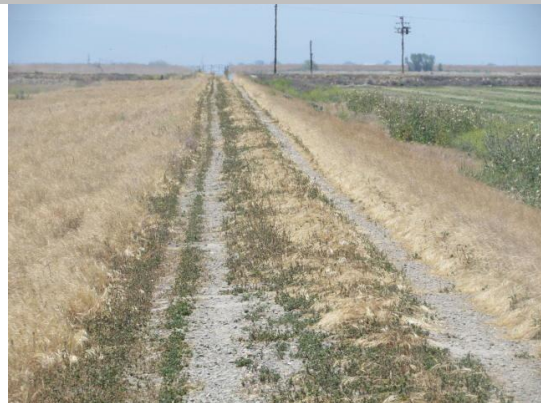
Photo 2 of 2 : FA_2015_NA0010_133_11_20150914_00002.jpg

Looking east at vegetation on levee crown. Spring 2015

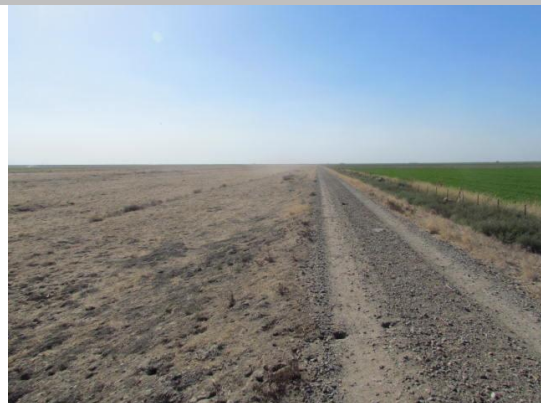
Photo 1 of 1 : FA_2015_NA0010_133_4_20151014_00004.jpg

Looking at typical view of waterward slope.

LM Start	0.02	Rating **	A	Issue No.	4
LM End	2.03	Issue Type +	Ma	Location *	WS
Category	Earthen Levee			GPS Latitude/Longitude	
				Start	End
Item	Vegetation			36.996566 °	°
				-120.410043 °	°
DWR ID	DWR_NA0010_15_f_2015_4				
Action/Comments					
Remove the wild growth other than native grasses from the levee slopes.

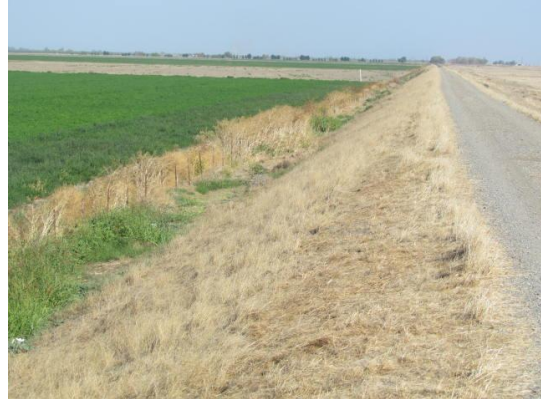
Photo 1 of 1 : FA_2015_NA0010_133_3_20151014_00005.jpg

Looking at typical view of landward slope.

LM Start	0.02	Rating **	A	Issue No.	3
LM End	2.03	Issue Type +	Ma	Location *	LS
Category	Earthen Levee			GPS Latitude/Longitude	
				Start	End
Item	Vegetation			36.996566 °	°
				-120.410042 °	°
DWR ID	DWR_NA0010_15_f_2015_3				
Action/Comments					
Remove the wild growth other than native grasses from the levee slopes.

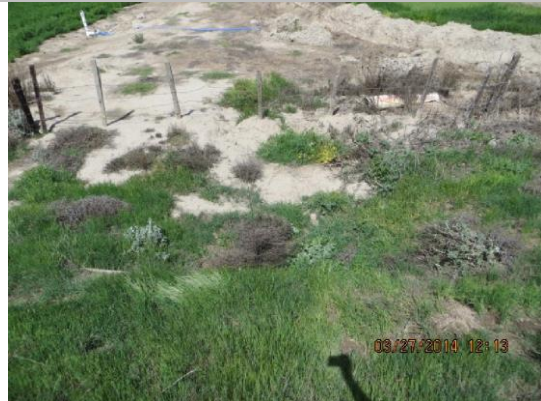
Photo 1 of 3 : UCIP_FA_2015_4613.jpg

Concrete headwall on LS toe.

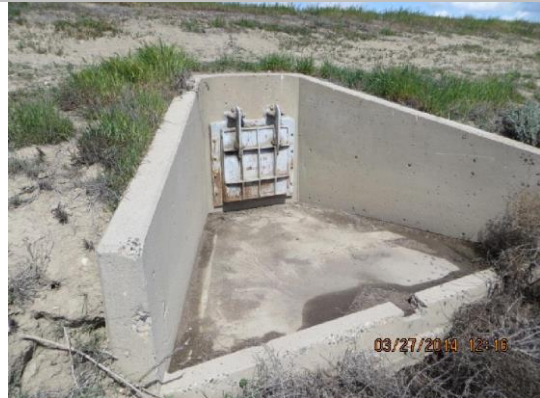
Photo 3 of 3 : UCIP_FA_2015_4615.jpg

Flapgate on concrete headwall at WS toe.

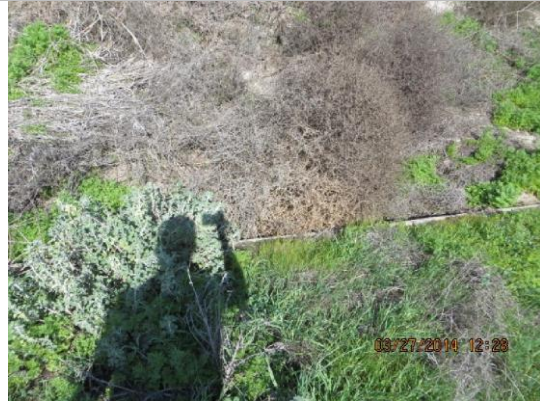
Photo 1 of 3 : UCIP_FA_2015_4635.jpg

Concrete headwall on LS toe. Note excessive vegetation buildup.

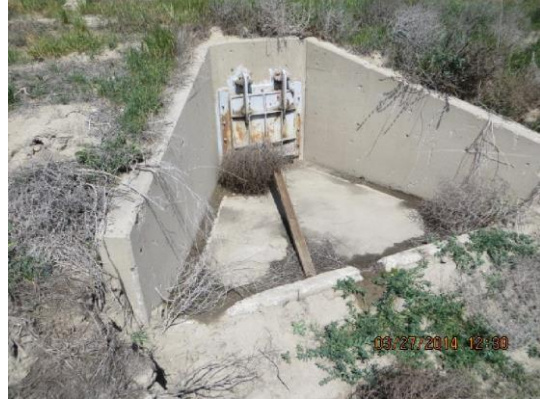
Photo 3 of 3 : UCIP_FA_2015_4637.jpg

LM Start	1.53	Rating **	M	Issue No.	13 (cont)
LM End	1.53	Issue Type +	En	Location *	LS
Category	Supplemental			GPS Latitude/Longitude	
				Start	End
Item	DWR UCIP Field Study			36.996582 °	36.996582 °
				-120.382757 °	-120.382757 °
DWR ID					
Action/Comments					
Inspector Comments: FS_ID:32840					
DS_ID:19913					
EP_NO: N/A					
FS_HLM: 1.531					
Repair Type: Non-Urgent					
Crossing Status: Found

Flapgate on concrete headwall at WS toe.

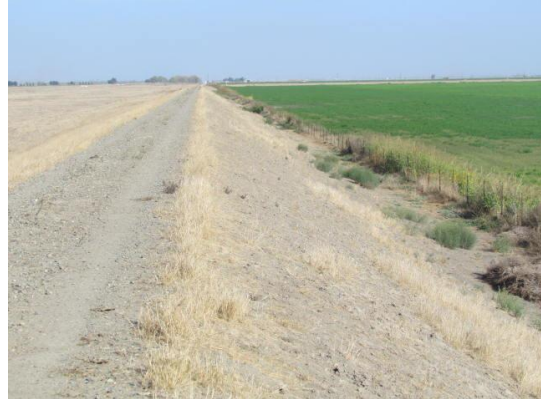
Photo 1 of 1 : FA_2015_NA0010_134_5_20151014_00006.jpg

LM Start	0.00	Rating **	A	Issue No.	5
LM End	1.96	Issue Type +	Ma	Location *	LS
Category	Earthen Levee			GPS Latitude/Longitude	
				Start	End
Item	Vegetation			36.995298 °	°
				-120.408943 °	°
DWR ID	DWR_NA0010_16_f _ 2015_5				
Action/Comments					
Remove the wild growth other than native grasses from the levee slopes.

Looking at typical view of landward slope.

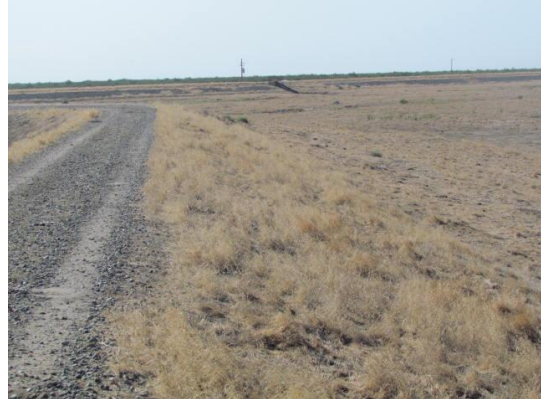
Photo 1 of 1 : FA_2015_NA0010_134_6_20151014_00005.jpg

LM Start	0.00	Rating **	A	Issue No.	6
LM End	1.96	Issue Type +	Ma	Location *	WS
Category	Earthen Levee			GPS Latitude/Longitude	
				Start	End
Item	Vegetation			36.995298 °	°
				-120.408942 °	°
DWR ID	DWR_NA0010_16_f_2015_6				
Action/Comments					
Remove the wild growth other than native grasses from the levee slopes.

Looking at typical view of waterward slope.

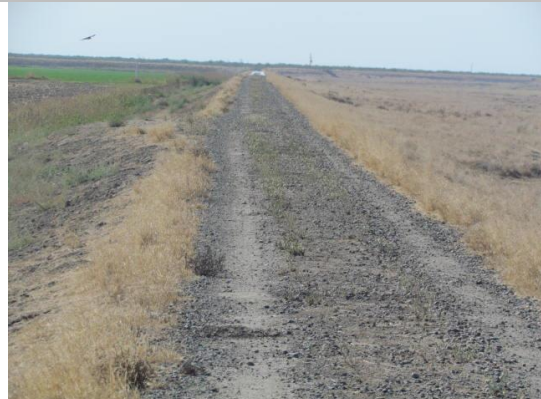
Photo 1 of 1 : FA_2015_NA0010_134_14_20151014_00007.jpg

LM Start	0.01	Rating **	A/W	Issue No.	14
LM End	1.96	Issue Type +	Ma	Location *	CR
Category	Earthen Levee			GPS Latitude/Longitude	
				Start	End
Item	Crown Surface / Depressions / Rutting			36.995388 °	36.995507 °
				-120.408738 °	-120.373592 °
DWR ID	DWR_NA0010_16_s_2012_14				
Action/Comments					
Add appropriate material and re-grade the levee to bring the crown above the design elevation.					
Inspector Comments: Control vegetation on levee crown.

Looking west at properly maintained levee crown.

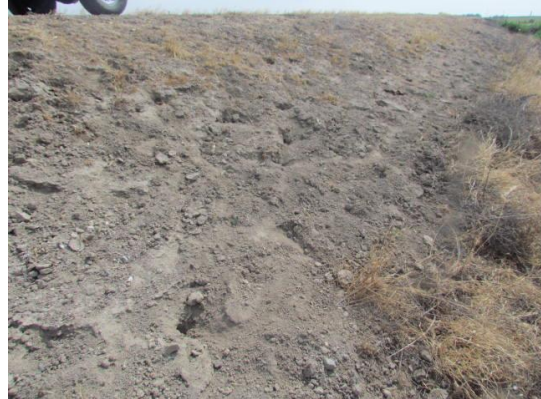
Photo 1 of 1 : FA_2015_NA0010_134_92_20150914_00004.jpg

LM Start	0.93	Rating **	M	Issue No.	92
LM End	0.93	Issue Type +	Ma	Location *	LS
Category	Earthen Levee			GPS Latitude/Longitude	
				Start	End
Item	Animal Control			36.995439 °	36.995439 °
				-120.392146 °	-120.392146 °
DWR ID	DWR_NA0010_16_s_2015_92				
Action/Comments					
No rodents visible, but rodent burrows visible; need to backfill and compact or grout burrows. Inspector Comments: Notice several rodent holes within this section.

Looking at several rodent holes on landward slope.

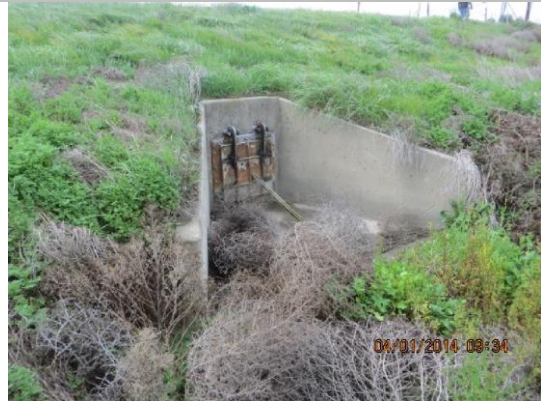
Photo 1 of 3 : UCIP_FA_2015_4269.jpg

LM Start	1.44	Rating **	M	Issue No.	93
LM End	1.44	Issue Type +	En	Location *	LS
Category	Supplemental			GPS Latitude/Longitude	
				Start	End
Item	DWR UCIP Field Study			36.995473 °	36.995473 °
				-120.382872 °	-120.382872 °
DWR ID					
Action/Comments					
Inspector Comments: FS_ID:39529 DS_ID:19915 EP_NO: N/A FS_HLM: 1.457 Repair Type: Non-Urgent Crossing Status: Found UCIP Comments: Dense vegetation buildup at landside toe-- recommend clearing. FIELD_STRUCT_DESC: 30-inch square R.C.B.C. through levee, 8.5 feet below crown. Concrete "U" headwall on waterward end. Two concrete cutoff walls. Flap gate on waterward side. Concrete headwall on landward end. (USACE-1967). This entry matches the Drainage or Irrigation Structure referenced in O&M manual (HLM 1.46). FS Date: 04/01/2014

Flapgate on headwall at WS toe.

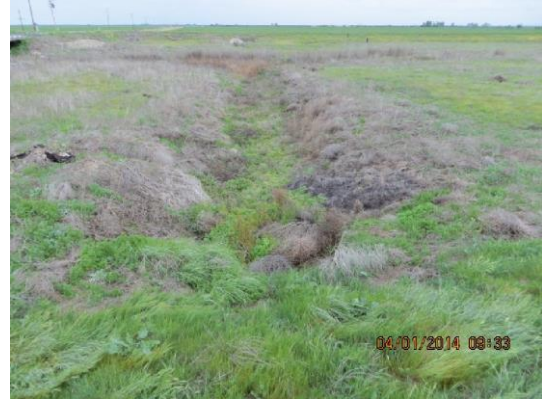
Photo 2 of 3 : UCIP_FA_2015_4270.jpg

Inspector Comments: FS_ID:39529
 DS_ID:19915
 EP_NO: N/A
 FS_HLM: 1.457
 Repair Type: Non-Urgent
 Crossing Status: Found
 UCIP Comments: Dense vegetation buildup at landside toe-- recommend clearing.
 FIELD_STRUCT_DESC: 30-inch square R.C.B.C. through levee, 8.5 feet below crown. Concrete "U" headwall on waterward end. Two concrete cutoff walls. Flap gate on waterward side. Concrete headwall on landward end. (USACE-1967). This entry matches the Drainage or Irrigation Structure referenced in O&M manual (HLM 1.46).
 FS Date: 04/01/2014

Concrete headwall on WS toe with channel.

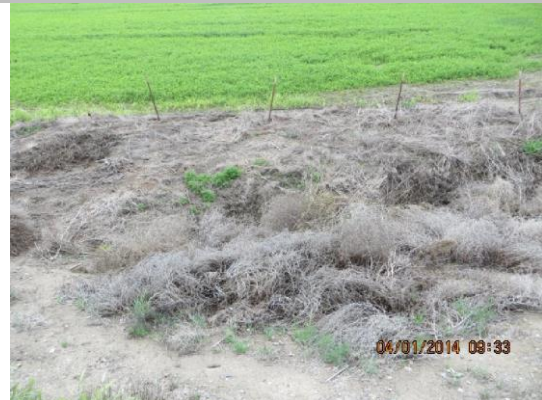
Photo 3 of 3 : UCIP_FA_2015_4271.jpg

Concrete headwall on LS toe covered in vegetation/tumble weeds.

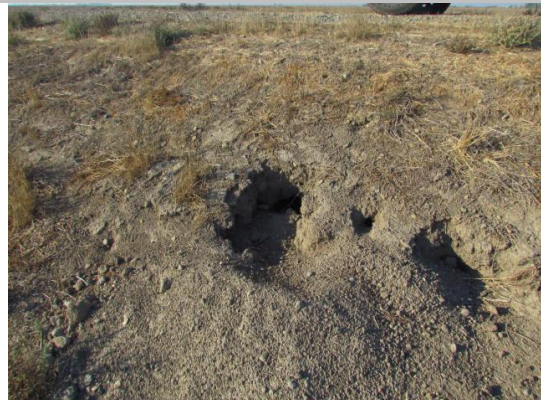
Photo 1 of 2 : FA_2015_NA0010_134_2_20150914_00001.jpg

LM Start	1.77	Rating **	U	Issue No.	2
LM End	1.77	Issue Type +	Ma	Location *	LS
Category	Earthen Levee			GPS Latitude/Longitude	
				Start	End
Item	Animal Control			36.995487 °	36.995487 °
				-120.377054 °	-120.377054 °
DWR ID	DWR_NA0010_16_f _ 2014_2				
Action/Comments					
No rodents visible, but rodent burrows visible; need to backfill and compact or grout burrows.					
Inspector Comments: Large rodent holes on landward slope.

Looking at large rodent holes on landward slope.

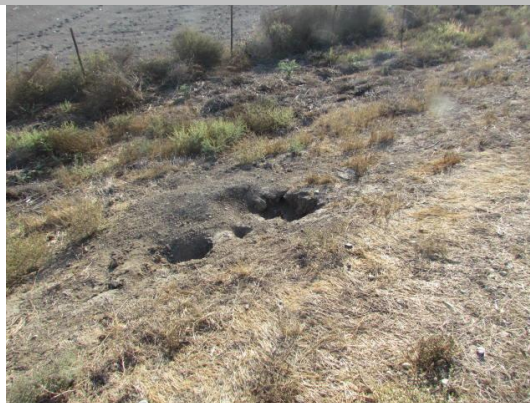
Photo 2 of 2 : FA_2015_NA0010_134_2_20150914_00002.jpg

LM Start	1.77	Rating **	U	Issue No.	2 (cont)	
LM End	1.77	Issue Type +	Ma	Location *	LS	
Category	Earthen Levee			GPS Latitude/Longitude		
				Start	End	
Item	Animal Control			36.995487 °	36.995487 °	
				-120.377054 °	-120.377054 °	
DWR ID	DWR_NA0010_16_f_2014_2					
Action/Comments						
No rodents visible, but rodent burrows visible; need to backfill and compact or grout burrows.						
Inspector Comments: Large rodent holes on landward slope.

Looking southwest at several rodent holes on landward slope.

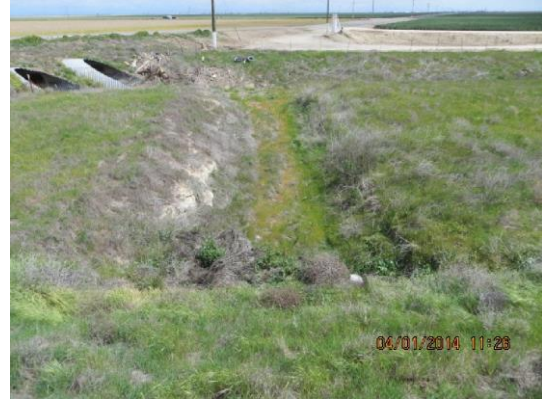
Photo 1 of 3 : UCIP_FA_2015_4066.jpg

LM Start	2.57	Rating **	M	Issue No.	12
LM End	2.57	Issue Type +	En	Location *	LS
Category	Supplemental			GPS Latitude/Longitude	
				Start	End
Item	DWR UCIP Field Study			36.952254 °	36.952254 °
				-120.348804 °	-120.348804 °
DWR ID					
Action/Comments					
Inspector Comments: FS_ID:39531					
DS_ID:19916					
EP_NO: N/A					
FS_HLM: 2.579					
Repair Type: Non-Urgent					
Crossing Status: Found					
UCIP Comments: Dense vegetation limits the inspector's visibility to identify signs of pipe failure (leaks) along the landward slope.					
Recommend removing vegetation along pipe alignment to conduct proper inspection of structure.					
FIELD_STRUCT_DESC: 48x60-inch R.C.B.C. through the levee, 14.6 feet below the crown. Concrete "U" headwall on the waterward end.					
Flap gate on the waterward end. Concrete headwall on the landward end. (USACE-1967). This entry matches the Drainage or Irrigation Structure referenced in O&M manual (HLM 2.58).

Concrete headwall at LS toe.

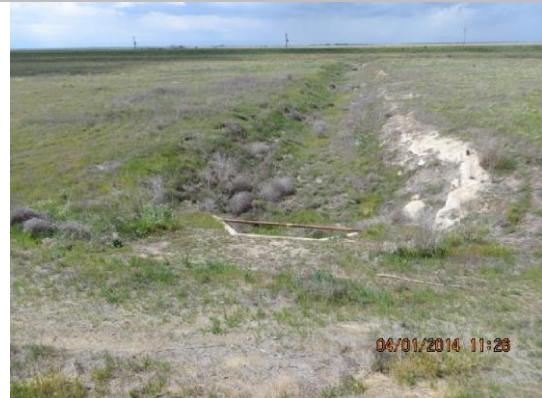
Photo 2 of 3 : UCIP_FA_2015_4067.jpg

Concrete headwall at channel on WS toe.

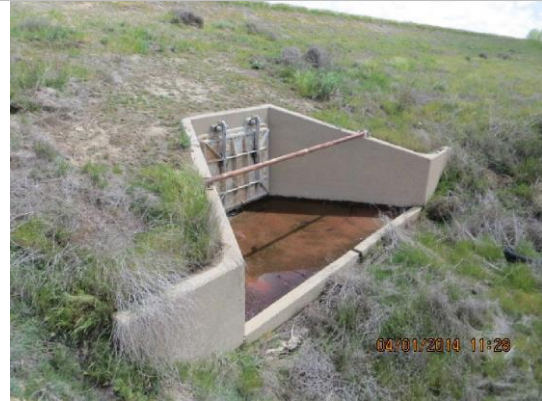
Photo 3 of 3 : UCIP_FA_2015_4068.jpg

LM Start	2.57	Rating **	M	Issue No.	12 (cont)
LM End	2.57	Issue Type +	En	Location *	LS
Category	Supplemental			GPS Latitude/Longitude	
				Start	End
Item	DWR UCIP Field Study			36.952254 °	36.952254 °
				-120.348804 °	-120.348804 °
DWR ID					
Action/Comments					
Inspector Comments: FS_ID:39531					
DS_ID:19916					
EP_NO: N/A					
FS_HLM: 2.579					
Repair Type: Non-Urgent					
Crossing Status: Found

Flapgate on Concrete headwall at WS toe.

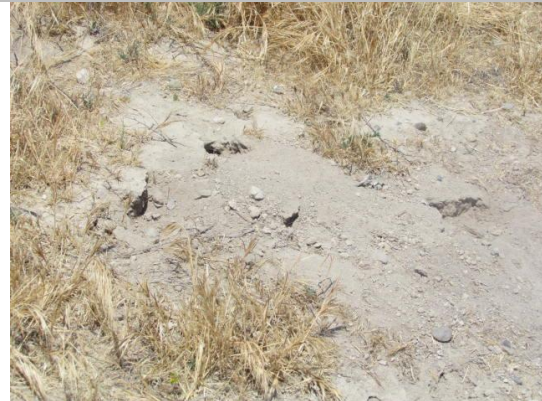
Photo 1 of 2 : FA_2015_NA0010_135_8_20150914_00004.jpg

LM Start	5.75	Rating **	M	Issue No.	8
LM End	5.90	Issue Type +	Ma	Location *	LS
Category	Earthen Levee			GPS Latitude/Longitude	
				Start	End
Item	Animal Control			36.908605 °	36.906507 °
				-120.331112 °	-120.330353 °
DWR ID	DWR_NA0010_17_s_2012_8				
Action/Comments					
Exterminate rodents and backfill and compact or grout burrows. Inspector Comments: Several rodent holes noted on landward slope.

Looking at several rodent holes on landward slope. (Spring 2015)

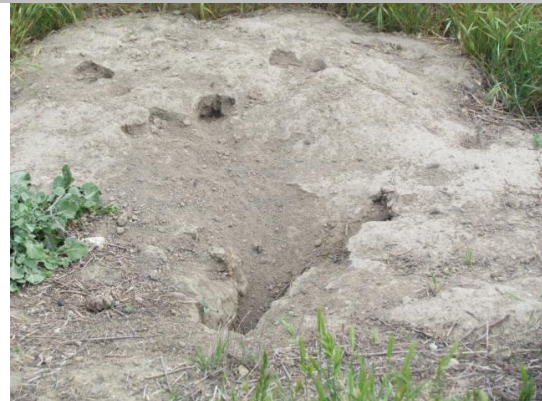
Photo 2 of 2 : FA_2015_NA0010_135_8_20150914_00005.jpg

LM Start	5.75	Rating **	M	Issue No.	8 (cont)
LM End	5.90	Issue Type +	Ma	Location *	LS

Looking at several rodent holes on landside slope. (Fall 2014)

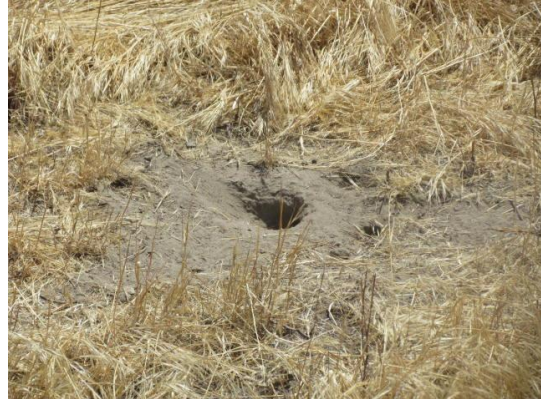
Photo 1 of 1 : FA_2015_NA0010_135_4_20150914_00002.jpg

LM Start	6.51	Rating **	M	Issue No.	4
LM End	6.60	Issue Type +	Ma	Location *	LS
Category	Earthen Levee			GPS Latitude/Longitude	
				Start	End
Item	Animal Control			36.898124 °	36.896943 °
				-120.326714 °	-120.326133 °
DWR ID	DWR_NA0010_17_s_2012_4				
Action/Comments					
Exterminate rodents and backfill and compact or grout burrows. Inspector Comments: Notice several rodent holes within this reach.

Looking at typical view of rodent holes on landward slope.

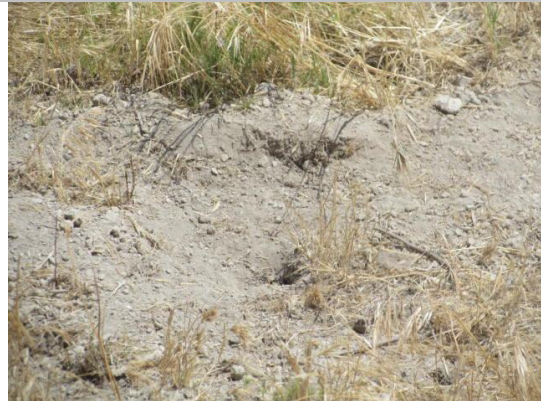
Photo 1 of 1 : FA_2015_NA0010_135_5_20150914_00003.jpg

LM Start	7.27	Rating **	M	Issue No.	5
LM End	7.38	Issue Type +	Ma	Location *	LS
Category	Earthen Levee			GPS Latitude/Longitude	
				Start	End
Item	Animal Control			36.887869 °	36.886341 °
				-120.321697 °	-120.320940 °
DWR ID	DWR_NA0010_17_s_2012_5				
Action/Comments					
No rodents visible, but rodent burrows visible; need to backfill and compact or grout burrows.					
Inspector Comments: Notice several rodent holes within this reach.

Looking at typical view of rodent holes on landward slope.

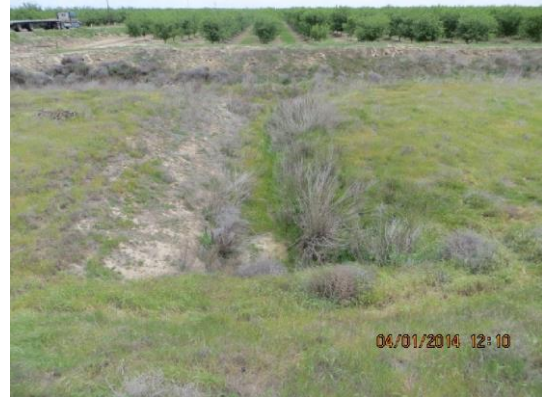
Photo 1 of 3 : UCIP_FA_2015_4069.jpg

LM Start	9.88	Rating **	M	Issue No.	13
LM End	9.88	Issue Type +	En	Location *	LS
Category	Supplemental			GPS Latitude/Longitude	
				Start	End
Item	DWR UCIP Field Study			36.850703 °	36.850703 °
				-120.314154 °	-120.314154 °
DWR ID					
Action/Comments					
Inspector Comments: FS_ID:39532 DS_ID:19917 EP_NO: N/A FS_HLM: 9.884 Repair Type: Non-Urgent Crossing Status: Found UCIP Comments: Dense vegetation limits the inspector's visibility to identify signs of pipe failure (leaks) along the landward slope. Recommend removing vegetation along pipe alignment to conduct proper inspection of structure. FIELD_STRUCT_DESC: 48x60-inch R.C.B.C. through the levee, 15-feet below the crown. Concrete "U" headwall on the waterward end. Concrete headwall on landward end. (USACE-1967). This entry matches the Drainage or Irrigation Structure referenced in O&M manual (HLM 9.89). FS Date: 04/01/2014

Concrete headwall and channel on LS toe.

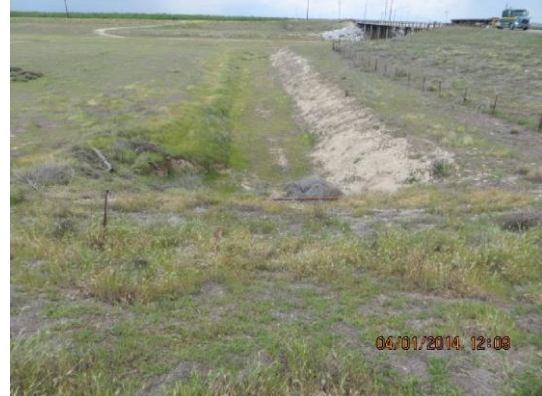
Photo 2 of 3 : UCIP_FA_2015_4070.jpg

Concrete headwall and channel on WS toe.

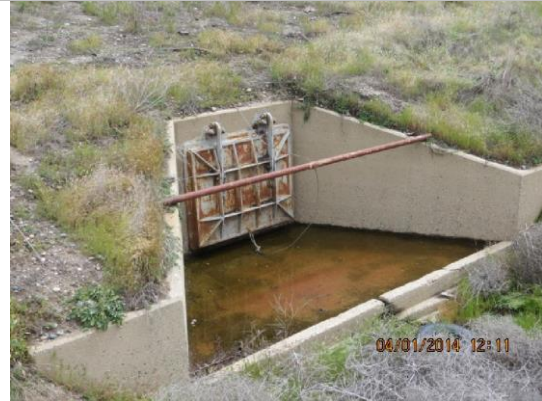
Photo 3 of 3 : UCIP_FA_2015_4071.jpg

LM Start	9.88	Rating **	M	Issue No.	13 (cont)
LM End	9.88	Issue Type +	En	Location *	LS
Category	Supplemental			GPS Latitude/Longitude	
				Start	End
Item	DWR UCIP Field Study			36.850703 °	36.850703 °
				-120.314154 °	-120.314154 °
DWR ID					
Action/Comments					
Inspector Comments: FS_ID:39532					
DS_ID:19917					
EP_NO: N/A					
FS_HLM: 9.884					
Repair Type: Non-Urgent					
Crossing Status: Found

Flapgate on Concrete headwall at WS toe.

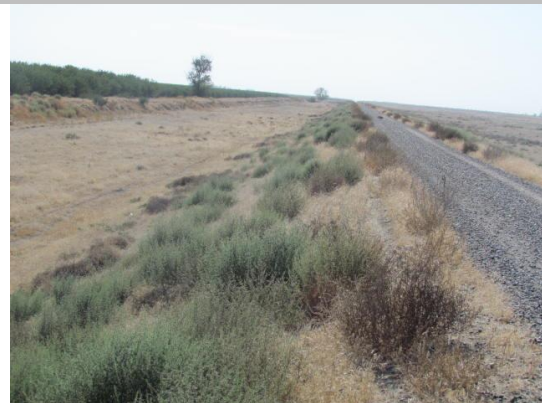
Photo 1 of 1 : FA_2015_NA0010_135_10_20151014_00006.jpg

LM Start	10.47	Rating **	M	Issue No.	10
LM End	16.08	Issue Type +	Ma	Location *	LS
Category	Earthen Levee			GPS Latitude/Longitude	
				Start	End
Item	Vegetation			36.842599 °	36.774510 °
				-120.312509 °	-120.283826 °
DWR ID	DWR_NA0010_17_f_2015_10				
Action/Comments					
Remove the wild growth other than native grasses from the levee slopes.					
Inspector Comments: Control tumble weeds on landward slope.

Looking southeast at landward slope.

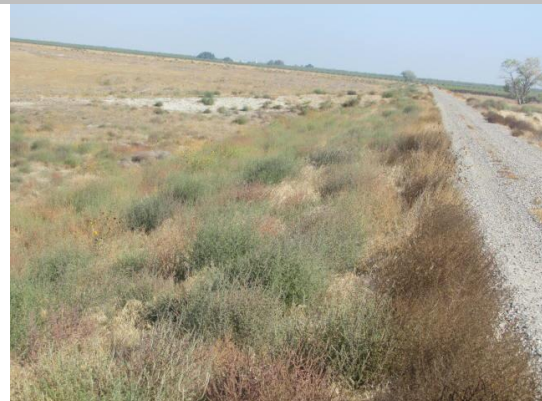
Photo 1 of 1 : FA_2015_NA0010_135_11_20151014_00007.jpg

LM Start	12.34	Rating **	M	Issue No.	11
LM End	16.08	Issue Type +	Ma	Location *	WS
Category	Earthen Levee			GPS Latitude/Longitude	
				Start	End
Item	Vegetation			36.820563 °	36.774510 °
				-120.300629 °	-120.283825 °
DWR ID	DWR_NA0010_17_f_2015_11				
Action/Comments					
Remove the wild growth other than native grasses from the levee slopes.					
Inspector Comments: Control new growth of tumble weeds on waterward slope.

Looking north at waterward slope.

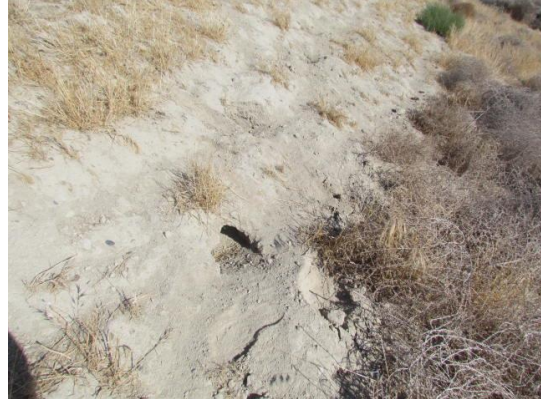
Photo 1 of 2 : FA_2015_NA0010_135_3_20151014_00008.jpg

LM Start	12.34	Rating **	M	Issue No.	3
LM End	12.37	Issue Type +	Ma	Location *	LS
Category	Earthen Levee			GPS Latitude/Longitude	
				Start	End
Item	Animal Control			36.820558 °	36.820155 °
				-120.300616 °	-120.300784 °
DWR ID	DWR_NA0010_17_s_2014_3				
Action/Comments					
No rodents visible, but rodent burrows visible; need to backfill and compact or grout burrows.					
Inspector Comments: Noted several rodent holes with this reach.

Looking at typical view of rodent holes on landward slope. Fall 2015

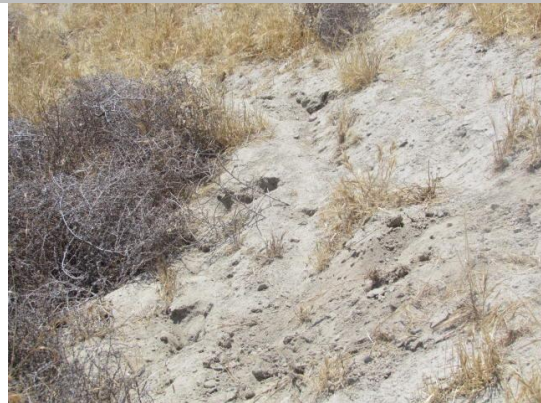
Photo 2 of 2 : FA_2015_NA0010_135_3_20150914_00001.jpg

Looking at several rodent holes on landward slope. Spring 2015

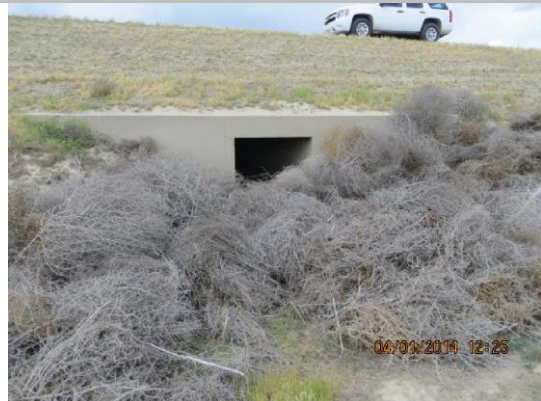
Photo 1 of 3 : UCIP_FA_2015_3533.jpg

LM Start	13.29	Rating **	M	Issue No.	14
LM End	13.29	Issue Type +	En	Location *	LS
Category	Supplemental			GPS Latitude/Longitude	
				Start	End
Item	DWR UCIP Field Study			36.807509 °	36.807509 °
				-120.306231 °	-120.306231 °
DWR ID					
Action/Comments					
Inspector Comments: FS_ID:39533 DS_ID:19918 EP_NO: N/A FS_HLM: 13.293 Repair Type: Non-Urgent Crossing Status: Found

Concrete headwall on LS toe. Some vegetation buildup.

Inspector Comments: FS_ID:39533
 DS_ID:19918
 EP_NO: N/A
 FS_HLM: 13.293
 Repair Type: Non-Urgent
 Crossing Status: Found
 UCIP Comments: Some vegetation buildup at inlet--recommend clearing.
 FIELD_STRUCT_DESC: 48x60-inch R.C.B.C. through the levee, 15.3 feet below the crown. Concrete "U" headwall on the waterward end. Flap gate on the waterward end. Concrete headwall on the landward end. (USACE-1967). This entry matches the Drainage or Irrigation Structure referenced in O&M manual (HLM 13.30).
 FS Date: 04/01/2014

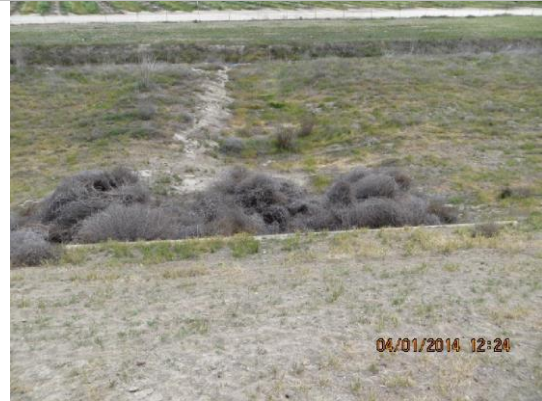
Photo 2 of 3 : UCIP_FA_2015_3534.jpg

Concrete headwall on LS toe.

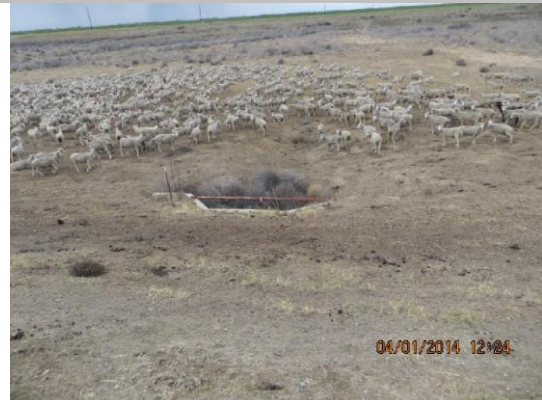
Photo 3 of 3 : UCIP_FA_2015_3535.jpg

Concrete headwall on WS toe.

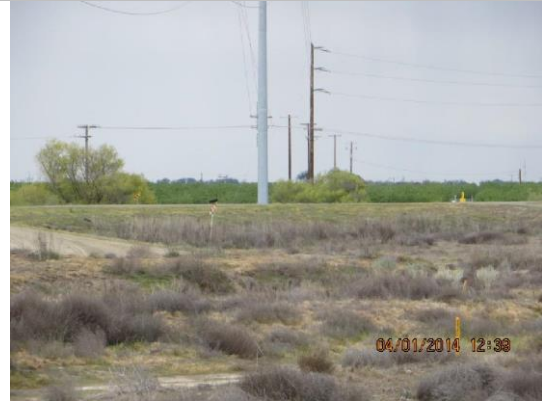
Photo 1 of 3 : UCIP_FA_2015_5938.jpg

LM Start	14.38	Rating **	M	Issue No.	15
LM End	14.38	Issue Type +	En	Location *	LS
Category	Supplemental			GPS Latitude/Longitude	
				Start	End
Item	DWR UCIP Field Study			36.793318 °	36.793318 °
				-120.302138 °	-120.302138 °
DWR ID					
Action/Comments					
Inspector Comments: FS_ID:41406					
DS_ID:24850					
EP_NO: N/A					
FS_HLM: 14.385					
Repair Type: Non-Urgent					
Crossing Status: Indicator Found

Gasline markers visible along right side of photo.

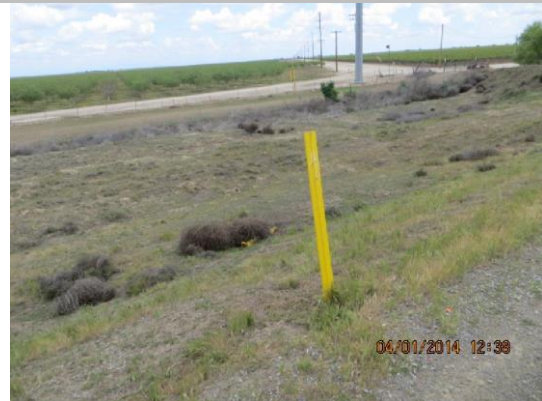
Photo 2 of 3 : UCIP_FA_2015_5939.jpg

Gasline marker on LS shoulder.

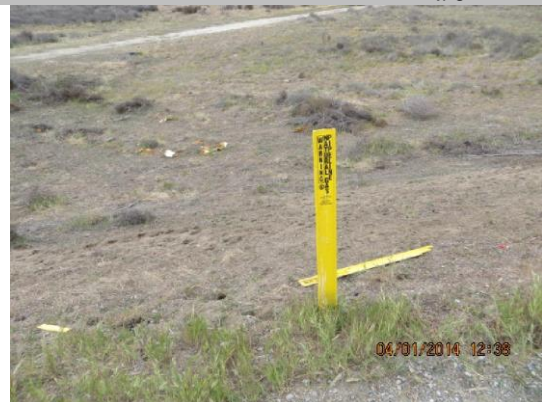
Photo 3 of 3 : UCIP_FA_2015_5940.jpg

Gasline marker on WS slope..

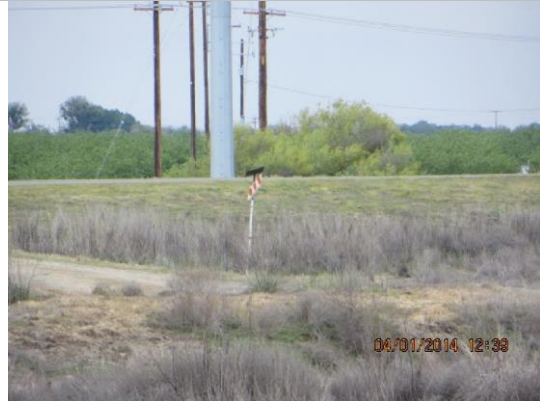
Photo 1 of 2 : UCIP_FA_2015_3536.jpg

LM Start	14.39	Rating **	U	Issue No.	16
LM End	14.39	Issue Type +	En	Location *	LS
Category	Supplemental			GPS Latitude/Longitude	
				Start	End
Item	DWR UCIP Field Study			36.793195 °	36.793195 °
				-120.302028 °	-120.302028 °
DWR ID					
Action/Comments					
Inspector Comments: FS_ID:39534					
DS_ID:19562					
EP_NO: 18568					
FS_HLM: 14.396					
Repair Type: Urgent					
Crossing Status: Indicator Found

Gasline marker visible in channell off WS toe.

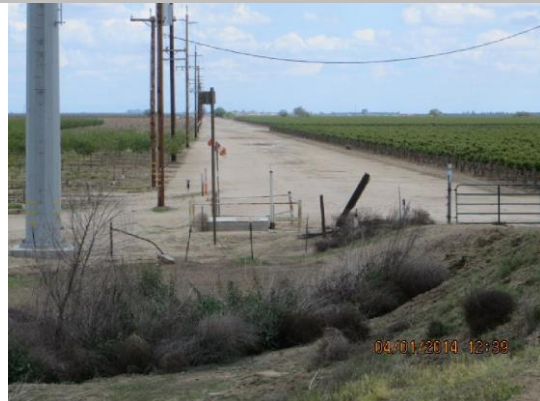
Photo 2 of 2 : UCIP_FA_2015_3537.jpg

Gasline marker and concrete sump off LS toe.

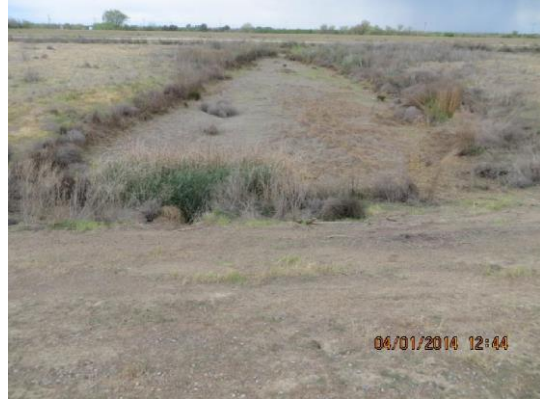
Photo 1 of 3 : UCIP_FA_2015_3538.jpg

LM Start	14.69	Rating **	M	Issue No.	17
LM End	14.69	Issue Type +	En	Location *	LS
Category	Supplemental			GPS Latitude/Longitude	
				Start	End
Item	DWR UCIP Field Study			36.789066 °	36.789066 °
				-120.300644 °	-120.300644 °
DWR ID					
Action/Comments					
Inspector Comments: FS_ID:39535					
DS_ID:19920					
EP_NO: N/A					
FS_HLM: 14.691					
Repair Type: Non-Urgent					
Crossing Status: Found

Concrete headwall at WS toe.

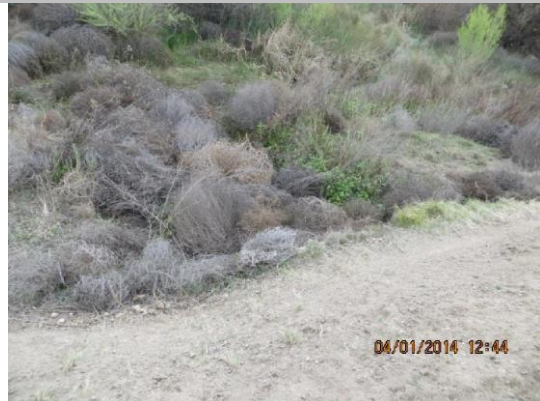
Photo 2 of 3 : UCIP_FA_2015_3573.jpg

Concrete headwall at channel on LS toe. Heavy vegetation buildup.

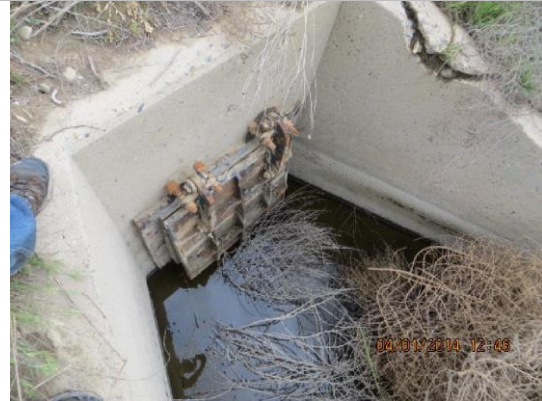
Photo 3 of 3 : UCIP_FA_2015_3574.jpg

Flapgate on Concrete headwall at WS toe.

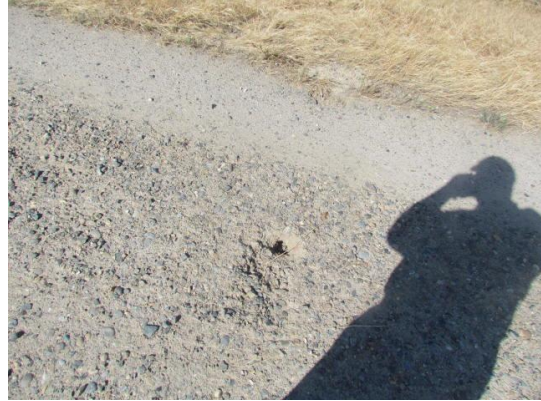
Photo 1 of 1 : FA_2015_NA0010_137_7_20150914_00002.jpg

LM Start	1.44	Rating **	M	Issue No.	7
LM End	1.44	Issue Type +	Ma	Location *	LS
Category	Earthen Levee			GPS Latitude/Longitude	
				Start	End
Item	Animal Control			36.956163 °	36.956163 °
				-120.353672 °	-120.353672 °
DWR ID	DWR_NA0010_18_s_2014_7				
Action/Comments					
No rodents visible, but rodent burrows visible; need to backfill and compact or grout burrows. Inspector Comments: Several noted on landward slope and on levee crown.

Looking at typical view of rodent holes within this section on landward slope.

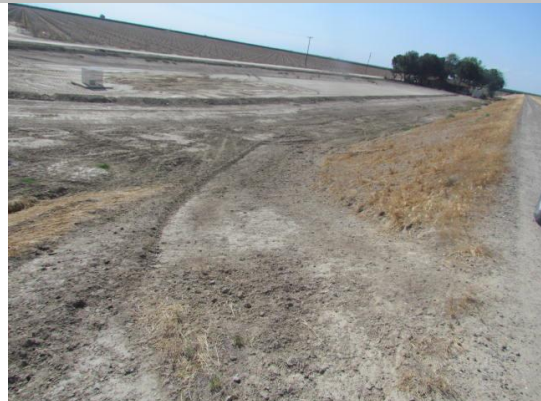
Photo 1 of 3 : FA_2015_NA0010_137_367_20150914_00003.jpg

LM Start	1.65	Rating **	A	Issue No.	367
LM End	1.65	Issue Type +	En	Location *	LS
Category	Earthen Levee			GPS Latitude/Longitude	
				Start	End
Item	Encroachments			36.953398 °	36.953398 °
				-120.351982 °	-120.351982 °
DWR ID	DWR_NA0010_18_s_2015_367				
Action/Comments					
Ramp					
Inspector Comments: Ramp has been inplace for several years. Need to check for permit.

Looking northwest at unauthorized ramp on landward slope.

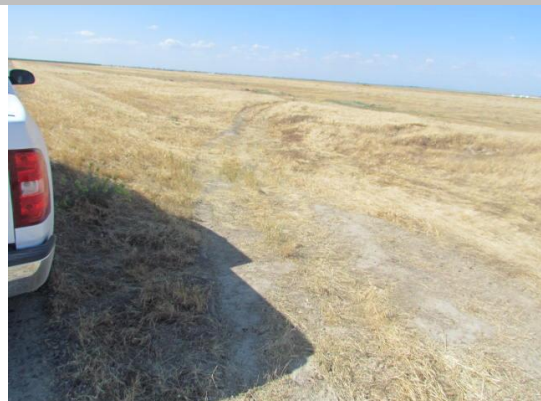
Photo 2 of 3 : FA_2015_NA0010_137_367_20150914_00004.jpg

Looking northeast on at unauthorized ramp on waterward slope.

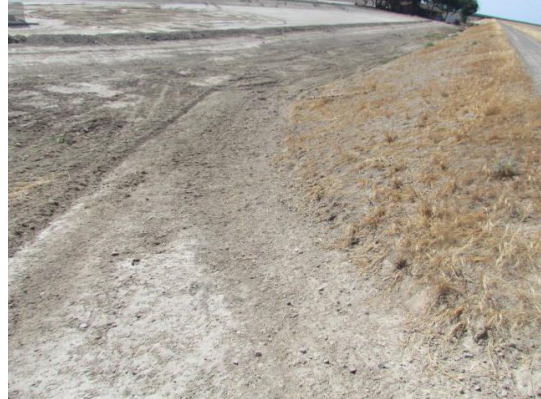
Photo 3 of 3 : FA_2015_NA0010_137_367_20150914_00005.jpg

Looking northwest at close-up view of ramp on landward slope.

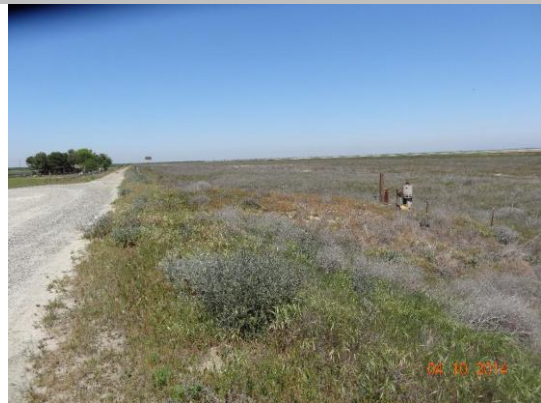
Photo 1 of 3 : UCIP_FA_2015_3150.jpg

LM Start	1.69	Rating **	M	Issue No.	368
LM End	1.69	Issue Type +	En	Location *	LS
Category	Supplemental			GPS Latitude/Longitude	
				Start	End
Item	DWR UCIP Field Study			36.952821 °	36.952821 °
				-120.351597 °	-120.351597 °
DWR ID					
Action/Comments					
Inspector Comments: FS_ID:39503 DS_ID:19925 EP_NO: 6603 FS_HLM: 1.69 Repair Type: Non-Urgent Crossing Status: Found UCIP Comments: Need to contact owner. Appears abandoned--good candidate for video or pressure inspection. This crossings is the same age as the pipe that has failed immediately upstream. FIELD_STRUCT_DESC: 15-inch steel pipe through the levee, 4.3 feet below the crown. Electrical conduit through the levee, 4.3 feet below the crown. Siphon breaker on landward shoulder. 36-inch concrete standpipe on landward berm. Inlet facility on waterward bank consisting of pump, 42-inch concrete standpipe, and 20-inch concrete channel intake pipe with cutoff wall. (Permit No. 6603-1970) FS Date: 04/10/2014

View of waterward side.

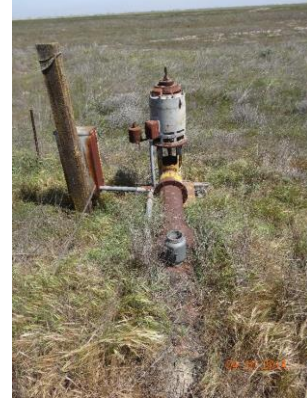
Photo 2 of 3 : UCIP_FA_2015_3151.jpg

Pump system located on waterward slope.

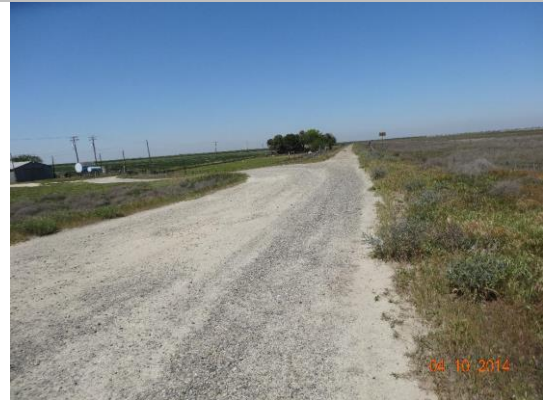
Photo 3 of 3 : UCIP_FA_2015_3152.jpg

Overview of levee crown at crossing.

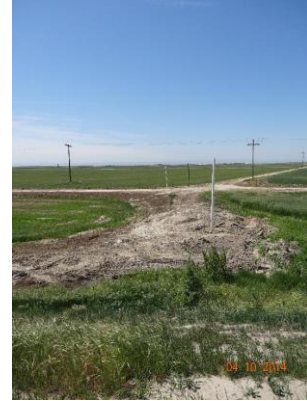
Photo 1 of 3 : UCIP_FA_2015_3810.jpg

LM Start	2.25	Rating **	U	Issue No.	369
LM End	2.25	Issue Type +	En	Location *	LS
Category	Supplemental			GPS Latitude/Longitude	
				Start	End
Item	DWR UCIP Field Study			36.945577 °	36.945577 °
				-120.347140 °	-120.347140 °
DWR ID					
Action/Comments					
Inspector Comments: FS_ID:43089					
DS_ID:19926					
EP_NO: 6603					
FS_HLM: 2.25					
Repair Type: Urgent					
Crossing Status: Found

Overview of landward side--site modified.

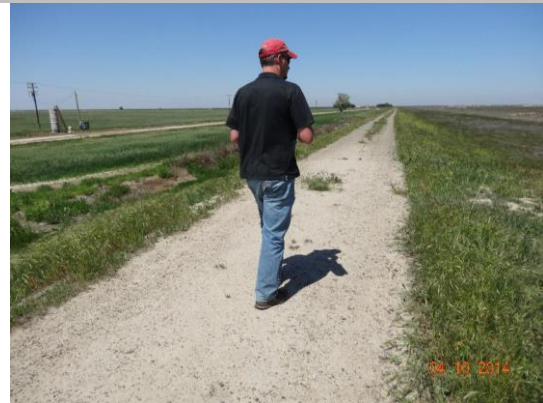
Photo 2 of 3 : UCIP_FA_2015_3811.jpg

View of levee crown at crossing.

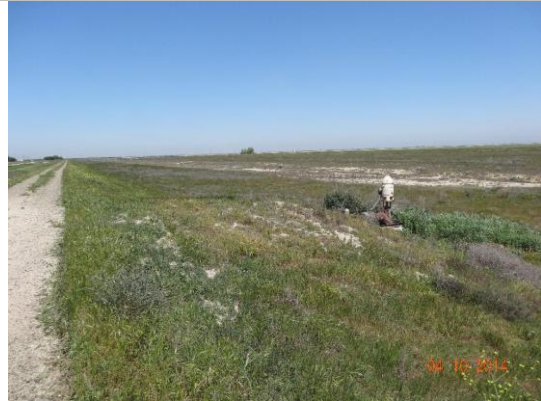
Photo 3 of 3 : UCIP_FA_2015_3812.jpg

View of waterward side.

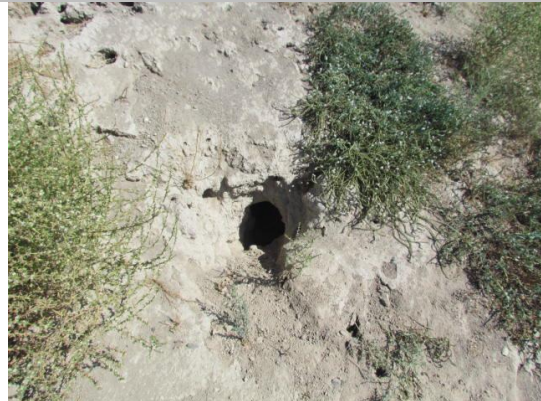
Photo 1 of 2 : FA_2015_NA0010_137_8_20151014_00006.jpg

LM Start	2.25	Rating **	U	Issue No.	8
LM End	2.25	Issue Type +	Ma	Location *	LS
Category	Earthen Levee			GPS Latitude/Longitude	
				Start	End
Item	Animal Control			36.945563 °	36.945563 °
				-120.347121 °	-120.347121 °
DWR ID	DWR_NA0010_18_f_2015_8				
Action/Comments					
No rodents visible, but rodent burrows visible; need to backfill and compact or grout burrows. Inspector Comments: One large rodent hole and other rodent holes within this area.

Looking at large rodent hole on landward slope.

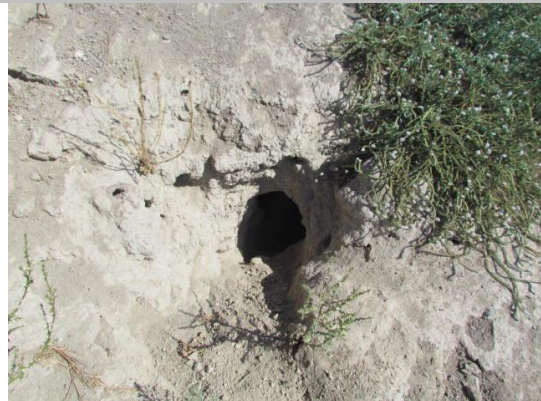
Photo 2 of 2 : FA_2015_NA0010_137_8_20151014_00007.jpg

Looking at close-up view of large rodent hole on landward slope.

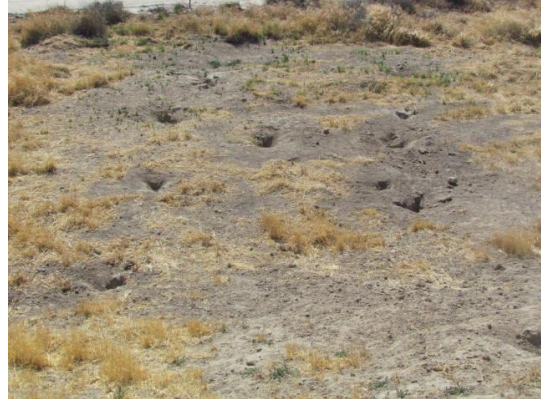
Photo 1 of 1 : FA_2015_NA0010_137_1_20150914_00001.jpg

LM Start	5.89	Rating **	M	Issue No.	1
LM End	5.89	Issue Type +	Ma	Location *	LS
Category	Earthen Levee			GPS Latitude/Longitude	
				Start	End
Item	Animal Control			36.895175 °	36.895175 °
				-120.327632 °	-120.327632 °
DWR ID	DWR_NA0010_18_s_2015_1				
Action/Comments					
No rodents visible, but rodent burrows visible; need to backfill and compact or grout burrows. Inspector Comments: Several large rodent holes noted on landward slope and berm within this section.

Looking at several rodent holes on landward slope.

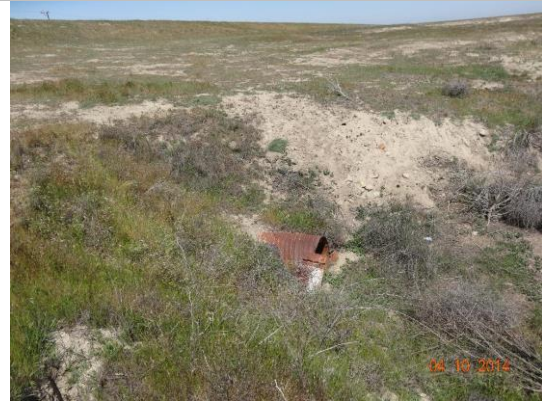
Photo 1 of 3 : UCIP_FA_2015_4814.jpg

Inspector Comments: FS_ID:36843
 DS_ID:19930
 EP_NO: N/A
 FS_HLM: 7.52
 Repair Type: Non-Urgent
 Crossing Status: Found
 UCIP Comments: CMP crossing is distorted on waterward side. Debris scattered on landward side. Sediment deposit inside crossing visible from landward side. Recommend removing debris from landward side.
 FIELD_STRUCT_DESC: 42-inch concrete pipe through the levee, 19.0 feet below the crown. Gate structure on waterward shoulder. Pipe section on waterward side is corrugated metal and pipe section on landward side is reinforced concrete. (Permit No. 13548-1984, New Stone Water District)
 FS Date: 04/10/2014

CMP section visible on waterward side.

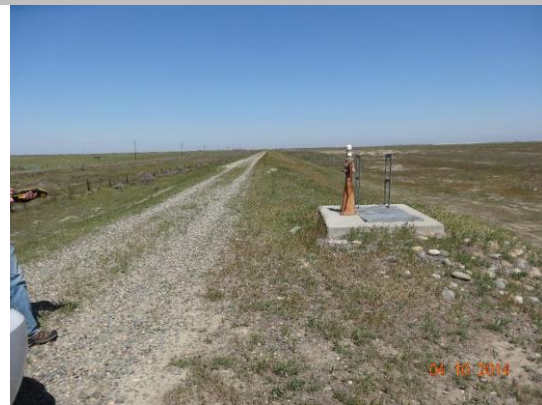
Photo 2 of 3 : UCIP_FA_2015_4815.jpg

Overview of levee crown at crossing--slide gate inside concrete box located on waterward shoulder.

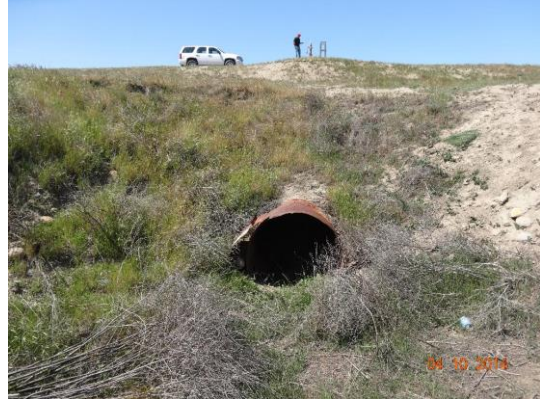
Photo 3 of 3 : UCIP_FA_2015_4816.jpg

Pipe section distorted on waterward side.

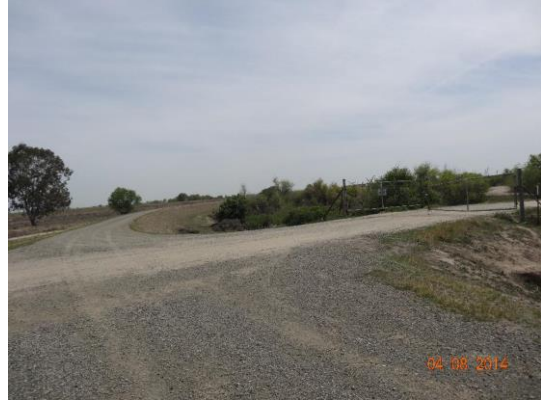
Photo 1 of 3 : UCIP_FA_2015_4350.jpg

LM Start	13.59	Rating **	M	Issue No.	371
LM End	13.59	Issue Type +	En	Location *	CR
Category	Supplemental			GPS Latitude/Longitude	
				Start	End
Item	DWR UCIP Field Study			36.792684 °	36.792684 °
				-120.304542 °	-120.304542 °
DWR ID					
Action/Comments					
Inspector Comments: FS_ID:39505 DS_ID:19932 EP_NO: N/A FS_HLM: 13.57 Repair Type: Non-Urgent Crossing Status: Indicator Found UCIP Comments: Multiple markers visible along waterward and landward sides unable to confirm how many crossings go through levee. Need to contact owner to obtain additional details on crossings. FIELD_STRUCT_DESC: 6-inch gas line through the levee. Extends underneath the channel. FS Date: 04/08/2014

Ramp visible on landward side.

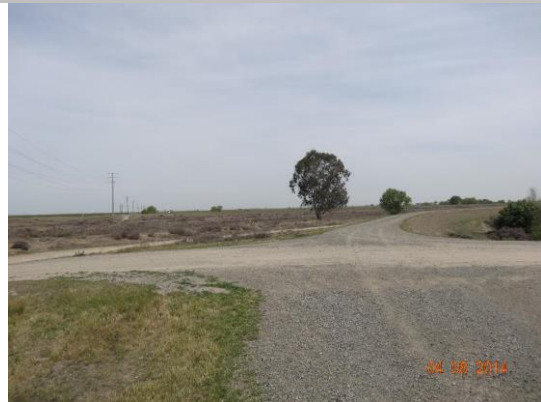
Photo 2 of 3 : UCIP_FA_2015_4351.jpg

View of levee crown at crossing.

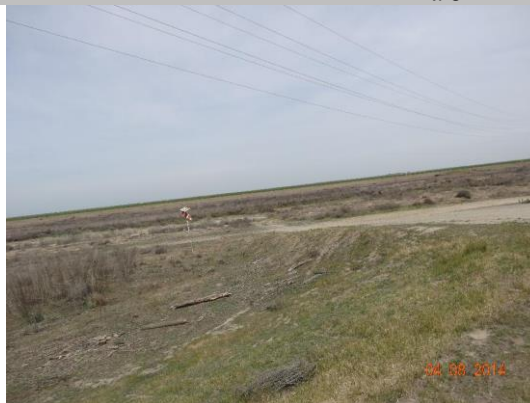
Photo 3 of 3 : UCIP_FA_2015_4352.jpg

LM Start	13.59	Rating **	M	Issue No.	371 (cont)
LM End	13.59	Issue Type +	En	Location *	CR
Category	Supplemental			GPS Latitude/Longitude	
				Start	End
Item	DWR UCIP Field Study			36.792684 °	36.792684 °
				-120.304542 °	-120.304542 °
DWR ID					
Action/Comments					
Inspector Comments: FS_ID:39505					
DS_ID:19932					
EP_NO: N/A					
FS_HLM: 13.57					
Repair Type: Non-Urgent					
Crossing Status: Indicator Found

Markers visible on waterward side.

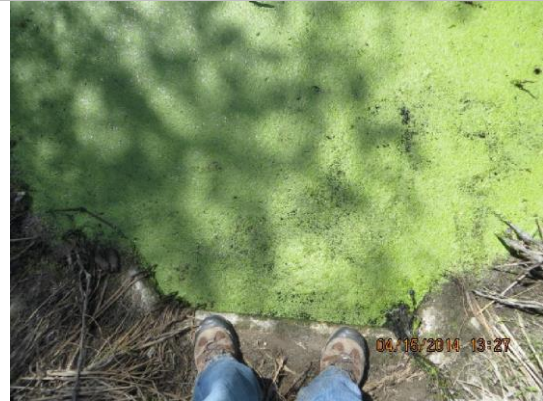
Photo 1 of 3 : UCIP_FA_2015_1238.jpg

Action/Comments					
Inspector Comments: FS_ID:39874 DS_ID:19933 EP_NO: N/A FS_HLM: 0.1 Repair Type: Urgent Crossing Status: Found UCIP Comments: No actuator wheel on slide gate at WS shoulder. FIELD_STRUCT_DESC: 24-inch CM stormdrain pipe through the levee, 14.8 feet below the crown. Slide gate inside 36-inch CM pipe riser in the waterward slope. Concrete "U" headwalls on both ends. (USACE-1967). This entry matches the Drainage or Irrigation Structure referenced in O&M manual (HLM 0.10). FS Date: 04/15/2014

Concrete headwall at LS toe.

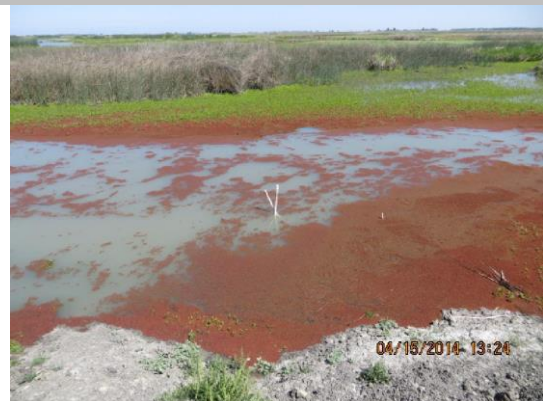
Photo 2 of 3 : UCIP_FA_2015_1239.jpg

PVC pipes sticking up out of channel likely indicate pipe location on WS toe.

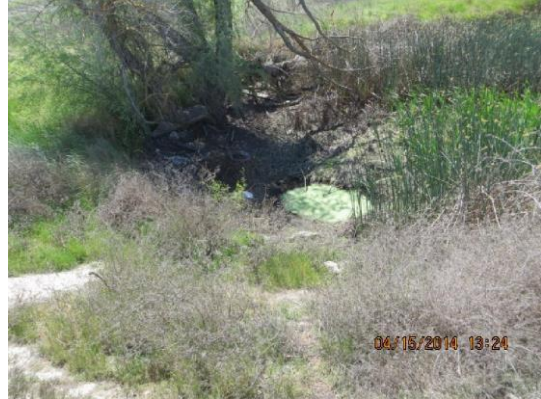
Photo 3 of 3 : UCIP_FA_2015_1240.jpg

Concrete headwall at toe of LS slope.

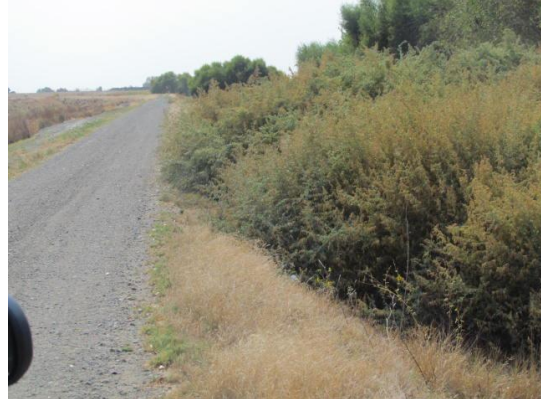
Photo 1 of 2 : FA_2015_NA0010_138_21_20151014_00020.jpg

LM Start	0.53	Rating **	U	Issue No.	21
LM End	0.53	Issue Type +	Ma	Location *	LS
Category	Earthen Levee			GPS Latitude/Longitude	
				Start	End
Item	Vegetation			37.213006 °	37.213006 °
				-120.698019 °	-120.698019 °
DWR ID	DWR_NA0010_22A_f_2014_21				
Action/Comments					
Remove the wild growth other than native grasses from the levee slopes.					
Inspector Comments: Dense vegetation on landward slope.

Looking at dense vegetation on landward slope. Fall 2015

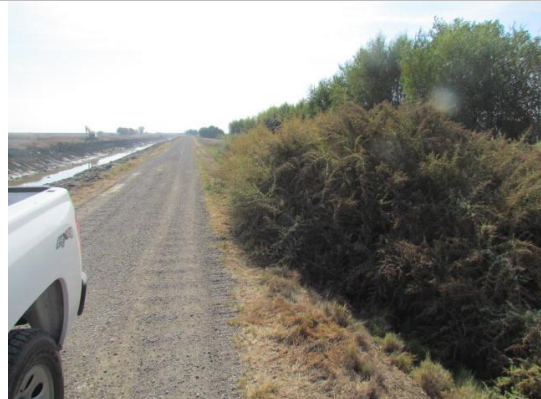
Photo 2 of 2 : FA_2015_NA0010_138_21_20150914_00014.jpg

Looking south at dense vegetation on landward slope. Spring 2015
