**Flood Control Project Maintenance
Levee Inspections**

Fall 2015 Levee Maintenance Deficiency Summary Report

San Joaquin River Basin

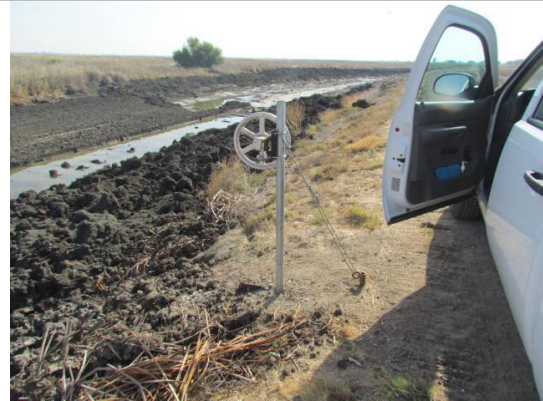
Photo 1 of 1 : FA_2015_NA0010_138_23_20150914_00018.jpg

LM Start	0.87	Rating **	M	Issue No.	23
LM End	0.87	Issue Type +	En	Location *	WS
Category	Earthen Levee			GPS Latitude/Longitude	
				Start	End
Item	Encroachments			37.217802 °	37.217802 °
				-120.697416 °	-120.697416 °
DWR ID	DWR_NA0010_22A_f_2014_23				
Action/Comments					
Sign Inspector Comments: Pulley on waterward shouder without board permit.

Looking south at pulley on waterward shoulder.

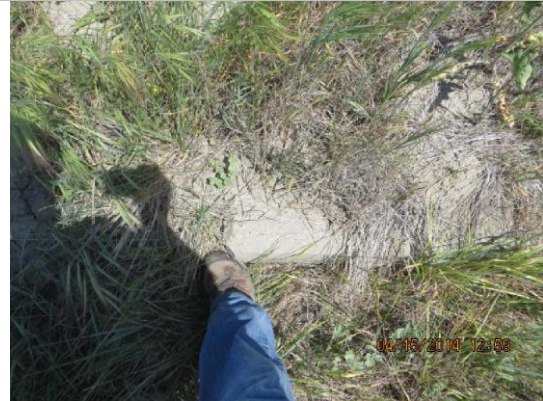
Photo 1 of 3 : UCIP_FA_2015_1235.jpg

Inspector Comments: FS_ID:33733
 DS_ID:19936
 EP_NO: N/A
 FS_HLM: 1.57
 Repair Type: Non-Urgent
 Crossing Status: Found
 UCIP Comments: Slide gate rusted and does not function. Headwall buried at LS toe. Pipe appears abandoned and if so should be done so properly.
 FIELD_STRUCT_DESC: 8-inch CM irrigation pipe through levee, 7.0-feet below the crown. Slide gate inside 36-inch CM pipe riser in the waterward slope. Concrete headwall on the landward end. (USACE-1967). This entry matches the Drainage or Irrigation Structure referenced in O&M manual (HLM 1.57).
 FS Date: 04/15/2014

Burried concrete headwall on LS toe.

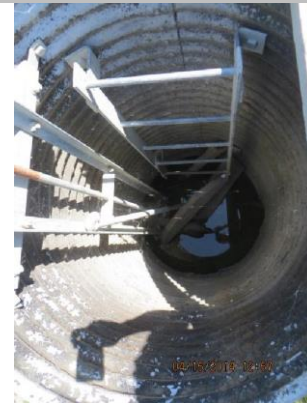
Photo 2 of 3 : UCIP_FA_2015_1236.jpg

Inside CMP riser on WS shoulder.

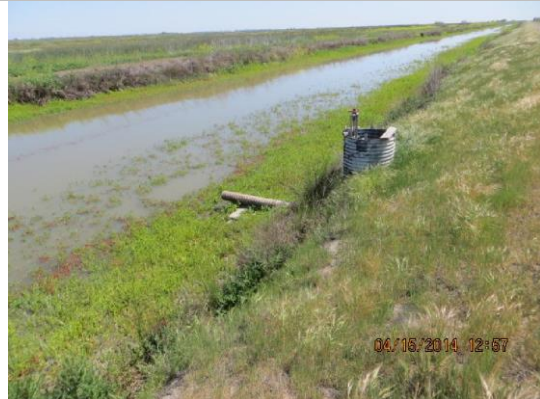
Photo 3 of 3 : UCIP_FA_2015_1237.jpg

Pipe and CMP riser with slide gate visible on WS slope.

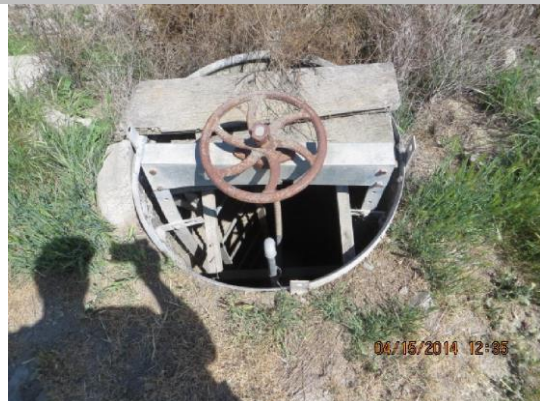
Photo 1 of 3 : UCIP_FA_2015_1234.jpg

LM Start	2.71	Rating **	M	Issue No.	262
LM End	2.71	Issue Type +	En	Location *	WS
Category	Supplemental			GPS Latitude/Longitude	
				Start	End
Item	DWR UCIP Field Study			37.243501 °	37.243501 °
				-120.706773 °	-120.706773 °
DWR ID					
Action/Comments					
Inspector Comments: FS_ID:33732					
DS_ID:19937					
EP_NO: N/A					
FS_HLM: 2.715					
Repair Type: Non-Urgent					
Crossing Status: Found					
UCIP Comments: Slide gate does not function and should be repaired.					
Headwall at LS toe not found.					
FIELD_STRUCT_DESC: 24-inch CM irrigation pipe through the levee, 7.5-feet below the crown. Slide gate inside 36-inch CM pipe riser in the waterward slope. Concrete "U" headwall on the landward end. (USACE-1967). This entry matches the Drainage or Irrigation Structure referenced in O&M manual (HLM 2.72).					
FS Date: 04/15/2014

Slidegate in CMP riser on WS shoulder. (Note: actuator does not work).

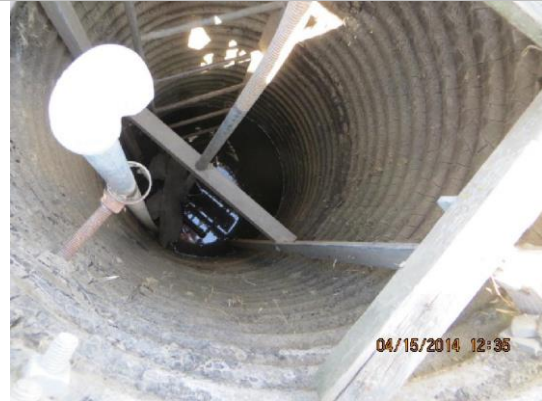
Photo 2 of 3 : UCIP_FA_2015_4699.jpg

Inspector Comments: FS_ID:33732
 DS_ID:19937
 EP_NO: N/A
 FS_HLM: 2.715
 Repair Type: Non-Urgent
 Crossing Status: Found
 UCIP Comments: Slide gate does not function and should be repaired.
 Headwall at LS toe not found.
 FIELD_STRUCT_DESC: 24-inch CM irrigation pipe through the levee,
 7.5-feet below the crown. Slide gate inside 36-inch CM pipe riser in the
 waterward slope. Concrete "U" headwall on the landward end. (USACE-
 1967). This entry matches the Drainage or Irrigation Structure
 referenced in O&M manual (HLM 2.72).
 FS Date: 04/15/2014

Inside CMP riser on WS shoulder.

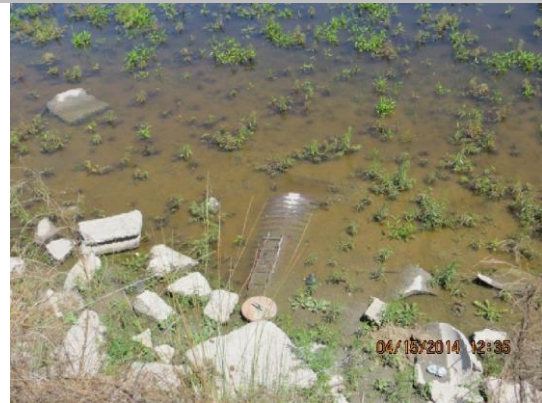
Photo 3 of 3 : UCIP_FA_2015_4700.jpg

Pipe visible on WS toe.

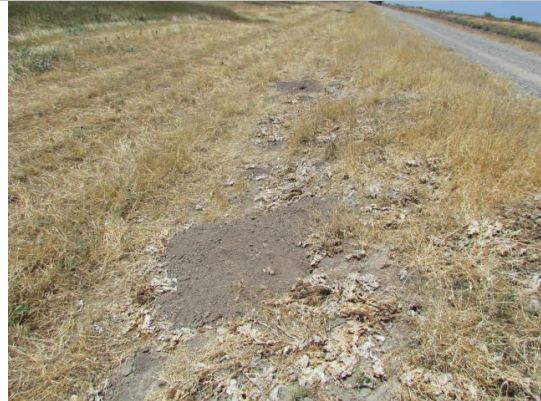
Photo 1 of 1 : FA_2015_NA0010_138_15_20150914_00013.jpg

LM Start	2.86	Rating **	M	Issue No.	15
LM End	3.05	Issue Type +	Ma	Location *	LS
Category	Earthen Levee			GPS Latitude/Longitude	
				Start	End
Item	Animal Control			37.245431 °	37.247343 °
				-120.707990 °	-120.710362 °
DWR ID	DWR_NA0010_22A_s _ 2014_15				
Action/Comments					
No rodents visible, but rodent burrows visible; need to backfill and compact or grout burrows. Inspector Comments: Noted several rodent holes on landward slope and toe.

Looking at several rodent holes on landward slope.

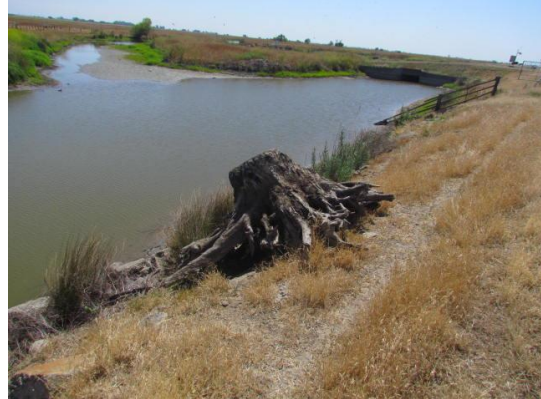
Photo 1 of 1 : FA_2015_NA0010_138_259_20150914_00019.jpg

LM Start	3.80	Rating **	M	Issue No.	259
LM End	3.80	Issue Type +	Ma	Location *	WS
Category	Earthen Levee			GPS Latitude/Longitude	
				Start	End
Item	Encroachments			37.255067 °	37.255067 °
				-120.719910 °	-120.719910 °
DWR ID	DWR_NA0010_22A_s _ 2015_259				
Action/Comments					
Tree or limb					
Inspector Comments: Dead tree stump on waterward slope.

Looking east at dead stump on waterward slope.

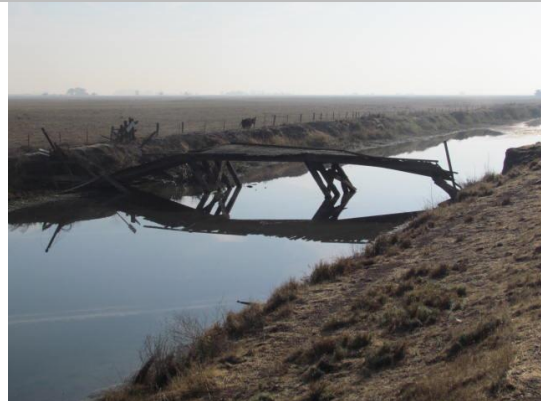
Photo 1 of 5 : FA_2015_NA0010_138_3_20150914_00001.jpg

LM Start	4.69	Rating **	A	Issue No.	3
LM End	4.69	Issue Type +	En	Location *	WS
Category	Rivers, Channels & Designated Floodways			GPS Latitude/Longitude	
				Start	End
Item	Encroachments			37.264250 °	37.264250 °
				-120.731280 °	-120.731280 °
DWR ID	DWR_NA0010_22A_f _ 2014_3				
Action/Comments					
Inspector Comments: Old wooden dilapidated bridge in channel has been removed.

Looking east at bridge in canal. (Fall 2014)

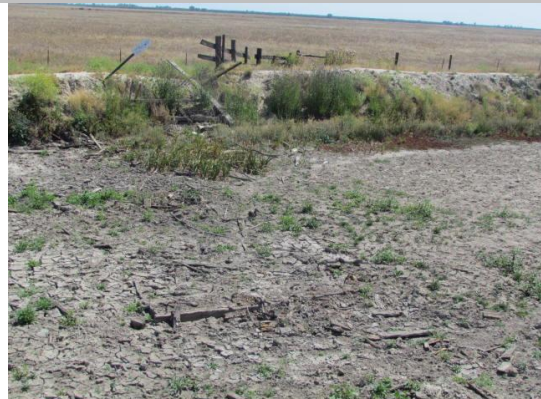
Photo 2 of 5 : FA_2015_NA0010_138_3_20150914_00002.jpg

Looking northeast at old site of dilapidated bridge. (Spring 2015)

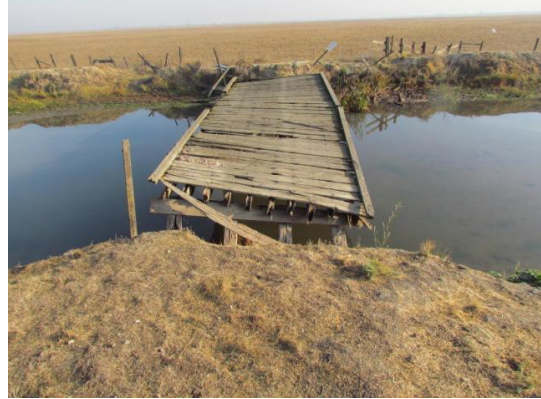
Photo 3 of 5 : FA_2015_NA0010_138_3_20150914_00003.jpg

Looking east at old bridge in canal. (Fall 2014)

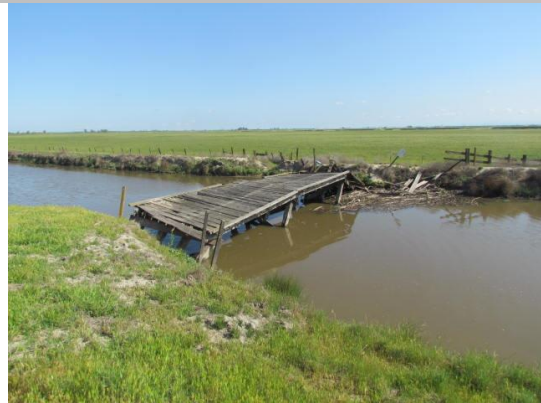
Photo 4 of 5 : FA_2015_NA0010_138_3_20150914_00004.jpg

Looking northeast at dilapidated bridge across canal.

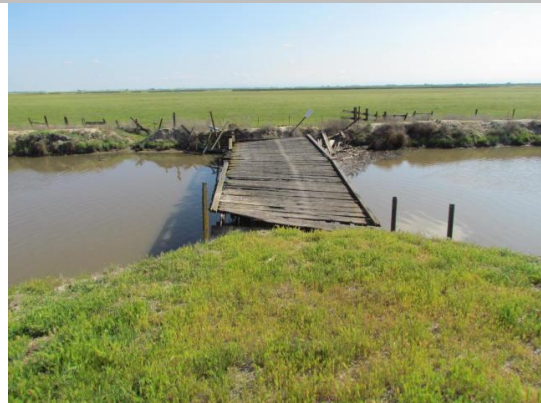
Photo 5 of 5 : FA_2015_NA0010_138_3_20150914_00005.jpg

Looking east at dilapidated bridge across canal.

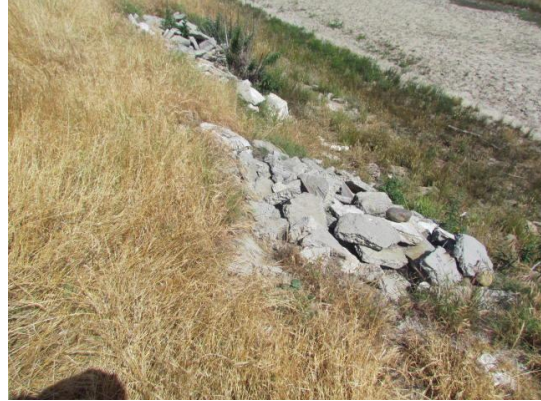
Photo 1 of 2 : FA_2015_NA0010_138_5_20150914_00008.jpg

LM Start	4.79	Rating **	A/W	Issue No.	5
LM End	4.86	Issue Type +	Ma	Location *	WS
Category	Earthen Levee			GPS Latitude/Longitude	
				Start	End
Item	Animal Control			37.265180 °	37.265743 °
				-120.732745 °	-120.733602 °
DWR ID	DWR_NA0010_22A_s_2012_5				
Action/Comments					
Repair the levee slope damaged by livestock and prevent large animal access.					
Inspector Comments: Erosion sites repaired by LMA on waterward toe.

Looking at erosion sites repaired with rip-rap on waterward slope and toe. (Spring 2015)

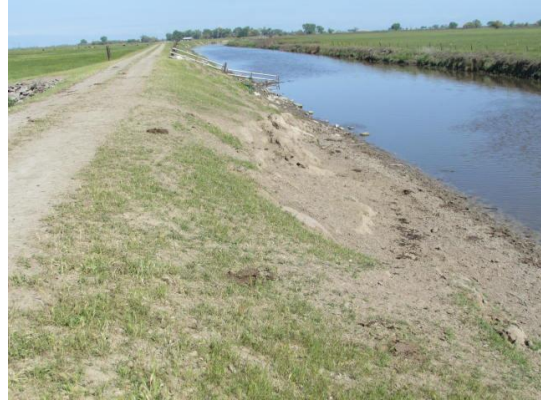
Photo 2 of 2 : FA_2015_NA0010_138_5_20150914_00009.jpg

Looking north at waterside erosion from livestock. (Fall 2014)

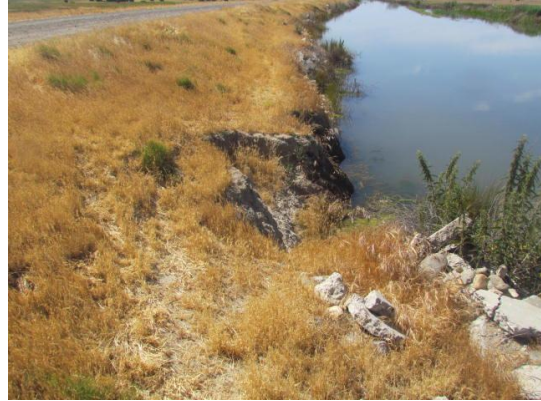
Photo 1 of 1 : FA_2015_NA0010_138_12_20150914_00012.jpg

LM Start	5.03	Rating **	M	Issue No.	12
LM End	5.03	Issue Type +	Ma	Location *	WS
Category	Earthen Levee			GPS Latitude/Longitude	
				Start	End
Item	Slope Stability			37.267271 °	37.267271 °
				-120.736067 °	-120.736067 °
DWR ID	DWR_NA0010_22A_s _ 2014_12				
Action/Comments					
Repair the levee slope damaged by foot traffic and prevent access where possible.					
Inspector Comments: Slope damage caused by animal traffic.

Looking south at slope damage cause by animal traffic on waterside slope.

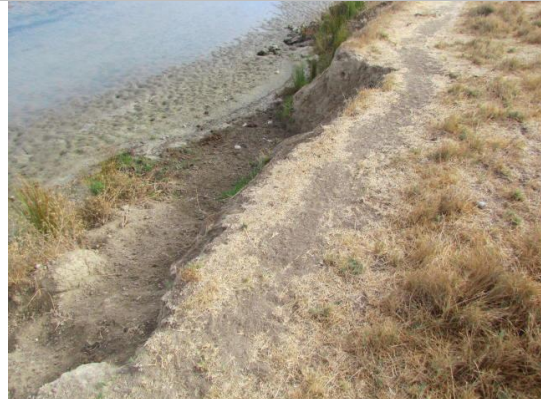
Photo 1 of 2 : FA_2015_NA0010_138_4_20150914_00006.jpg

LM Start	5.05	Rating **	M	Issue No.	4
LM End	5.05	Issue Type +	Ma	Location *	WS
Category	Earthen Levee			GPS Latitude/Longitude	
				Start	End
Item	Erosion / Bank Caving			37.267516 °	37.267516 °
				-120.736401 °	-120.736401 °
DWR ID	DWR_NA0010_22A_f _ 2013_4				
Action/Comments					
Schedule repair of erosion site prior to the next inspection.					
Inspector Comments: Erosion caused by animal traffic.

Looking southeast at livestock erosion on waterward toe.

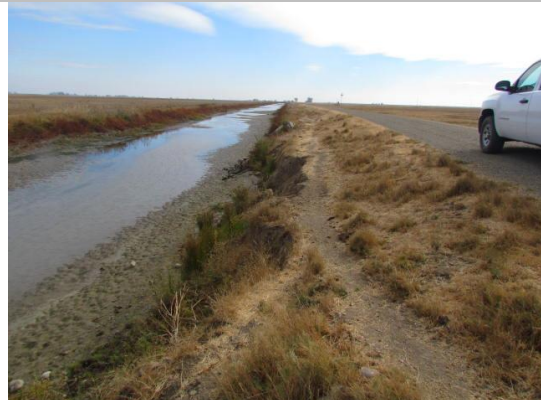
Photo 2 of 2 : FA_2015_NA0010_138_4_20150914_00007.jpg

Looking south livestock erosion on waterward toe.

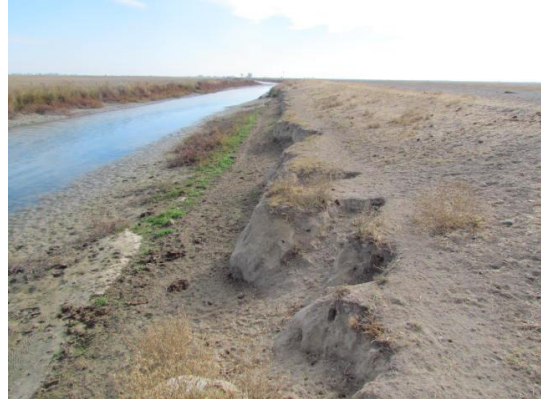
Photo 1 of 2 : FA_2015_NA0010_138_6_20150914_00010.jpg

LM Start	5.14	Rating **	M	Issue No.	6
LM End	5.20	Issue Type +	Ma	Location *	WS
Category	Earthen Levee			GPS Latitude/Longitude	
				Start	End
Item	Animal Control			37.268492 °	37.269133
				-120.737493 °	-120.738208
DWR ID	DWR_NA0010_22A_s_2012_6				
Action/Comments					
Repair the levee slope damaged by livestock and prevent large animal access.					
Inspector Comments: Erosion caused by livestock on waterside toe.

Looking south at livestock erosion on waterward toe.

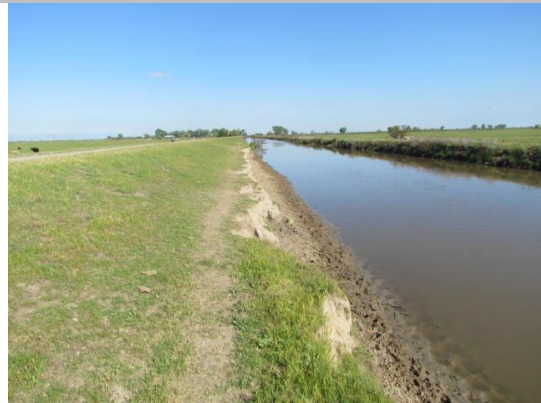
Photo 2 of 2 : FA_2015_NA0010_138_6_20150914_00011.jpg

Looking north at livestock erosion along waterside slope and toe.

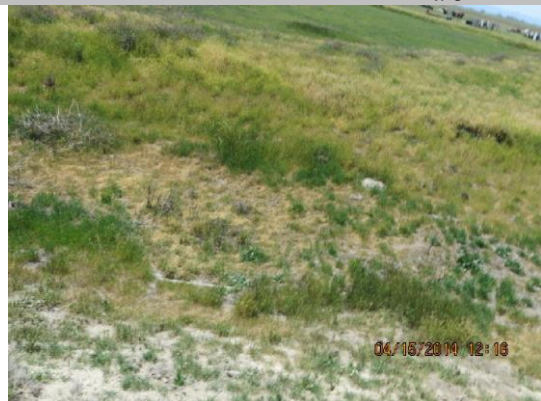
Photo 1 of 3 : UCIP_FA_2015_4696.jpg

LM Start	5.48	Rating **	M	Issue No.	263
LM End	5.48	Issue Type +	En	Location *	WS
Category	Supplemental			GPS Latitude/Longitude	
				Start	End
Item	DWR UCIP Field Study			37.272079 °	37.272079 °
				-120.741575 °	-120.741575 °
DWR ID					
Action/Comments					
Inspector Comments: FS_ID:39536 DS_ID:19938 EP_NO: N/A FS_HLM: 5.48 Repair Type: Non-Urgent Crossing Status: Found

Buried headwall on LS toe.

Inspector Comments: FS_ID:39536
 DS_ID:19938
 EP_NO: N/A
 FS_HLM: 5.48
 Repair Type: Non-Urgent
 Crossing Status: Found
 UCIP Comments: Need to contact owner. Pipe silted in on LS toe.
 Appears abandoned and if so should be done so properly.
 FIELD_STRUCT_DESC: 48-inch CM irrigation pipe through the levee,
 10 feet below the crown. Slide gate inside 60-inch CM pipe riser in the
 waterward slope. Concrete headwall on the landward end. Waterward
 end capped with 1/4-inch steel plate. (USACE-1967). This entry
 matches the Drainage or Irrigation Structure referenced in O&M manual
 (HLM 5.48).
 FS Date: 04/15/2014

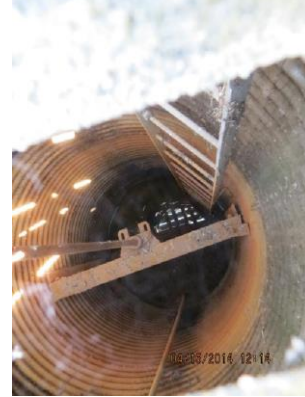
Photo 2 of 3 : UCIP_FA_2015_4697.jpg

Inside riser on WS shoulder.

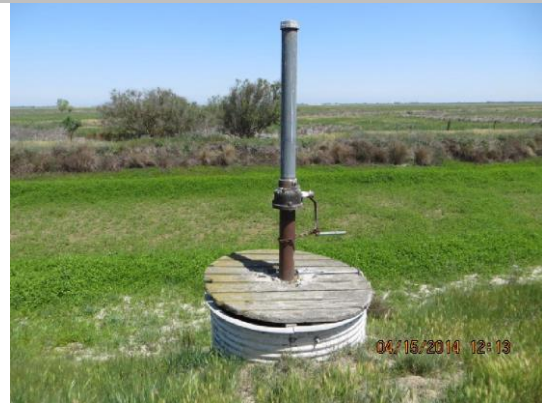
Photo 3 of 3 : UCIP_FA_2015_4698.jpg

Slidegate inside riser on WS shoulder.

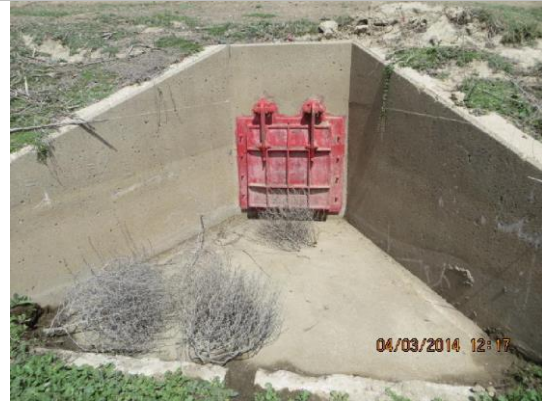
Photo 1 of 3 : UCIP_FA_2015_3799.jpg

Inspector Comments: FS_ID:39537
 DS_ID:19945
 EP_NO: N/A
 FS_HLM: 0.209
 Repair Type: Non-Urgent
 Crossing Status: Found
 UCIP Comments: Excessive vegetation at inlet--recommend clearing.
 FIELD_STRUCT_DESC: 30-inch square R.C.B.C. through the levee 13.0 feet below the crown. Concrete "U" headwall on the waterward end. Flap gate on the waterward end. Concrete headwall on the landward end. (USACE-1967). This entry matches the Drainage or Irrigation Structure referenced in O&M manual (HLM 0.21). Cleaned and rehabilitated under Permit No. 13085 (1981).
 FS Date: 04/03/2014

Flapgate on Concrete headwall at WS toe.

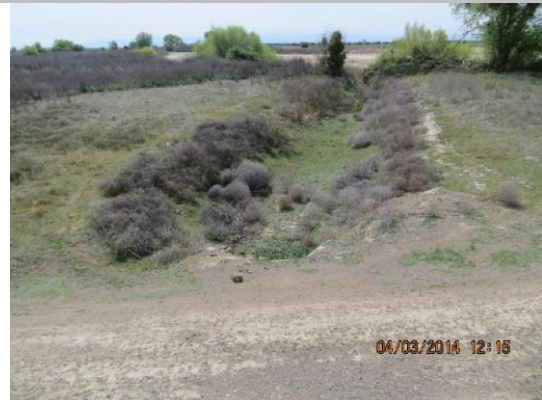
Photo 2 of 3 : UCIP_FA_2015_3800.jpg

Concrete headwall on WS toe at channel.

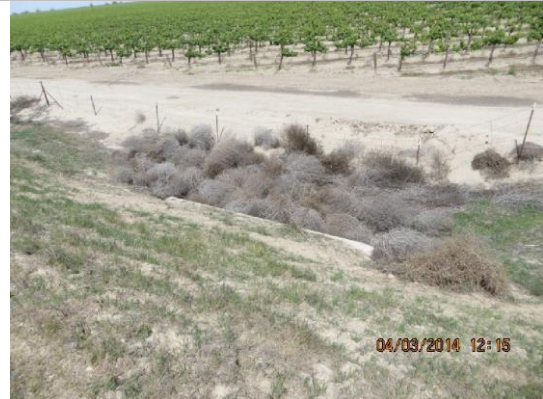
Photo 3 of 3 : UCIP_FA_2015_3801.jpg

Concrete headwall at LS toe. Excess vegetation buildup at inlet.

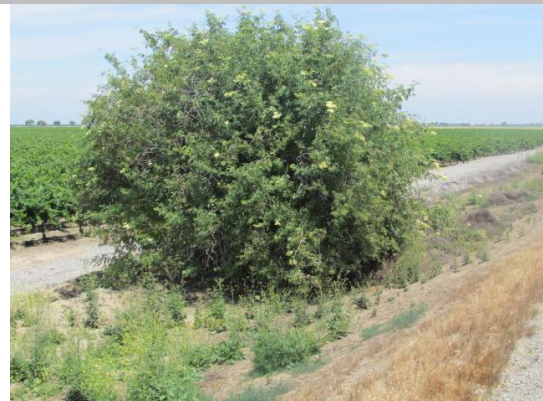
Photo 1 of 1 : FA_2015_NA0010_139_6_20150914_00005.jpg

LM Start	1.21	Rating **	M	Issue No.	6
LM End	1.21	Issue Type +	Ma	Location *	LS
Category	Earthen Levee			GPS Latitude/Longitude	
				Start	End
Item	Vegetation			36.772973 °	36.772973 °
				-120.264768 °	-120.264768 °
DWR ID	DWR_NA0010_23_s_2013_6				
Action/Comments					
Elderberries are blocking visibility and flood fight capability. Inspector Comments: Control growth of elderberry on landward toe.

Looking at elderberry on landward toe.

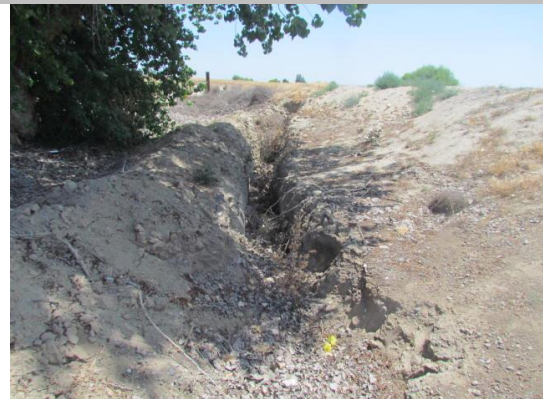
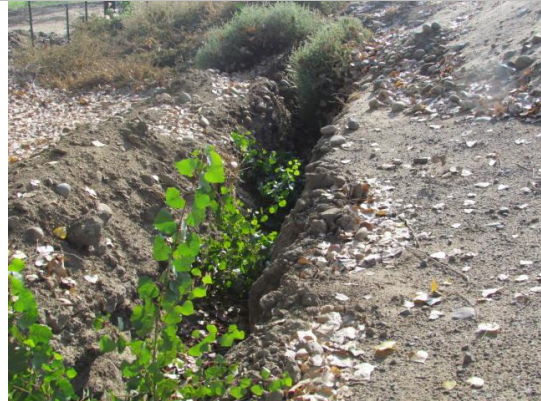
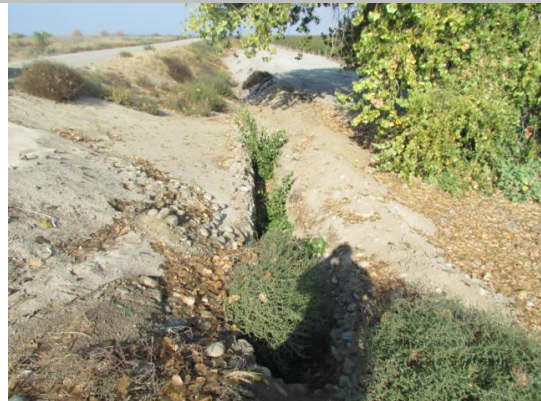
LM Start	1.53	Rating **	U	Issue No.	29
LM End	1.53	Issue Type +	En	Location *	LS
Category	Earthen Levee			GPS Latitude/Longitude	
				Start	End
Item	Encroachments			36.772041 °	36.772041 °
				-120.259549 °	-120.259549 °
DWR ID	DWR_NA0010_23_f_2014_29				
Action/Comments					
Ditch Inspector Comments: Trench at landward toe. Trench is ten to twelve inches wide and twenty feet long.

Looking south at trench at landward toe. (Spring 2015)

Looking south at trench at landward toe.

Looking north at trench at landward toe.

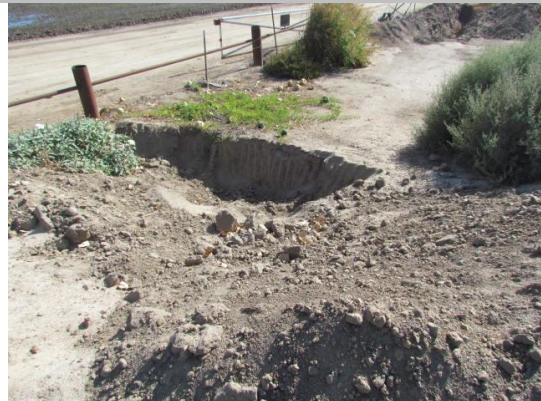
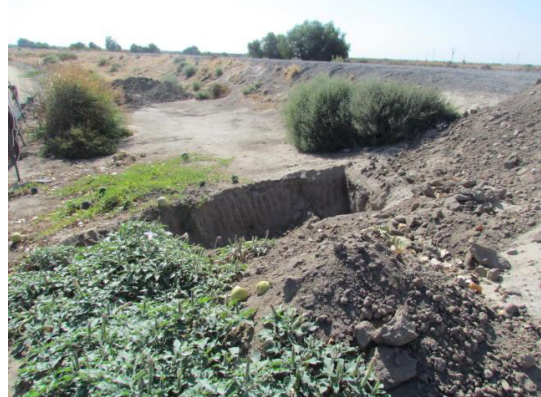
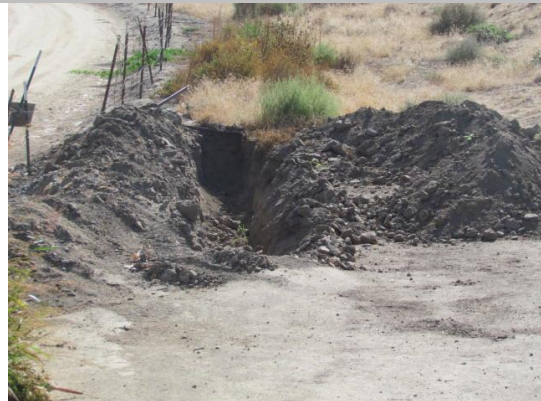
LM Start	1.54	Rating **	U	Issue No.	24
LM End	1.54	Issue Type +	En	Location *	LS
Category	Earthen Levee			GPS Latitude/Longitude	
				Start	End
Item	Encroachments			36.771922 °	36.771922 °
				-120.259321 °	-120.259321 °
DWR ID	DWR_NA0010_23_f_2015_24				
Action/Comments					
Ditch					
Inspector Comments: Landowner digging at landward berm.

Looking southeast at large pot hole on landward berm.

Looking south west at large pot hole on landward berm.

Looking south at trench on landward berm.

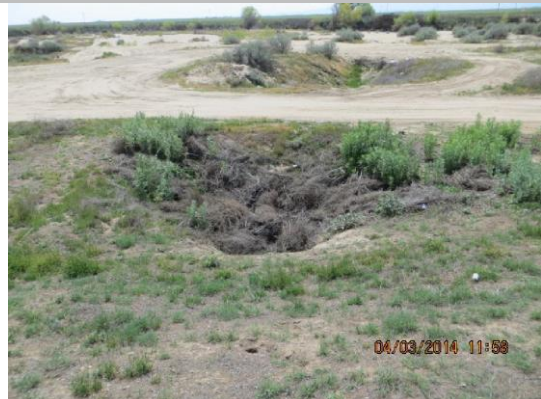
Photo 1 of 3 : UCIP_FA_2015_3796.jpg

LM Start	1.63	Rating **	M	Issue No.	31
LM End	1.63	Issue Type +	En	Location *	LS
Category	Supplemental			GPS Latitude/Longitude	
				Start	End
Item	DWR UCIP Field Study			36.771408 °	36.771408 °
				-120.257899 °	-120.257899 °
DWR ID					
Action/Comments					
Inspector Comments: FS_ID:39538 DS_ID:19948 EP_NO: N/A FS_HLM: 1.633 Repair Type: Non-Urgent Crossing Status: Found

Concrete headwall on WS toe.

Inspector Comments: FS_ID:39538
 DS_ID:19948
 EP_NO: N/A
 FS_HLM: 1.633
 Repair Type: Non-Urgent
 Crossing Status: Found
 UCIP Comments: Appears abandoned and if so should be done properly. Discharge channel is blocked by sand and soil making drain ineffective. Soil buildup at inlet on LS toe. Need to contact owner.
 FIELD_STRUCT_DESC: 30-inch square R.C.B.C. through the levee, 11.0 feet below the crown. Concrete "U" headwall on the waterward end. Flap gate on the waterward end. Concrete headwall on the landward end.
 FS Date: 04/03/2014

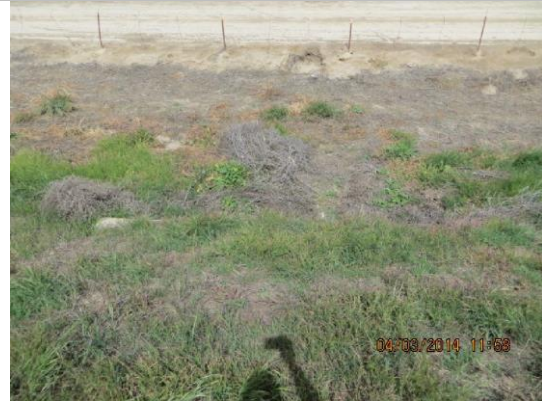
Photo 2 of 3 : UCIP_FA_2015_3797.jpg

Concrete headwall on LS toe.

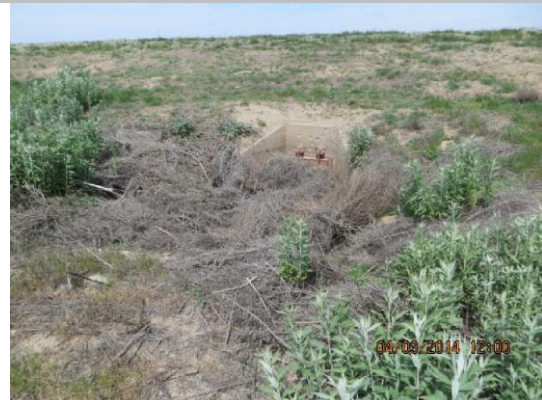
Photo 3 of 3 : UCIP_FA_2015_3798.jpg

Flapgate on Concrete headwall at WS toe.

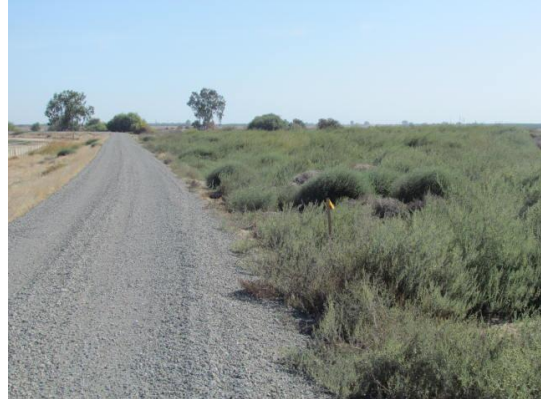
Photo 1 of 1 : FA_2015_NA0010_139_25_20151014_00024.jpg

LM Start	1.65	Rating **	U	Issue No.	25
LM End	1.72	Issue Type +	Ma	Location *	WS
Category	Earthen Levee			GPS Latitude/Longitude	
				Start	End
Item	Vegetation			36.771440 °	36.771619 °
				-120.257528 °	-120.256277 °
DWR ID	DWR_NA0010_23_f_2015_25				
Action/Comments					
Remove the wild growth other than native grasses from the levee slopes. Inspector Comments: Dense vegetation (tumble weeds) on waterward slope.

Looking at dense vegetation (tumble weeds) on waterward slope.

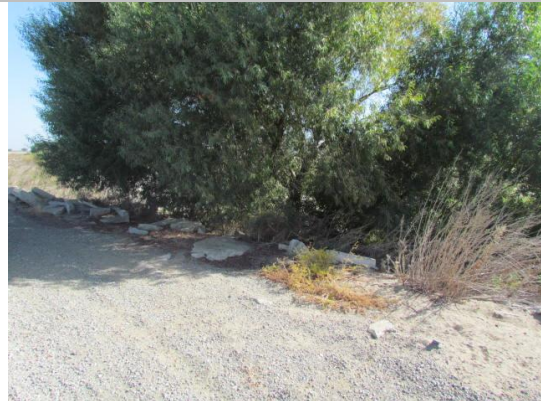
Photo 1 of 1 : FA_2015_NA0010_139_1_20151014_00025.jpg

LM Start	1.91	Rating **	U	Issue No.	1
LM End	1.91	Issue Type +	Ma	Location *	WS
Category	Earthen Levee			GPS Latitude/Longitude	
				Start	End
Item	Trim / Thin Trees			36.772943 °	36.772943 °
				-120.253511 °	-120.253511 °
DWR ID	DWR_NA0010_23_s_2015_1				
Action/Comments					
Trim trees to at least five feet above ground level.					
Inspector Comments: Untrimmed tree on waterward slope

Looking at untrimmed tree on waterward slope.

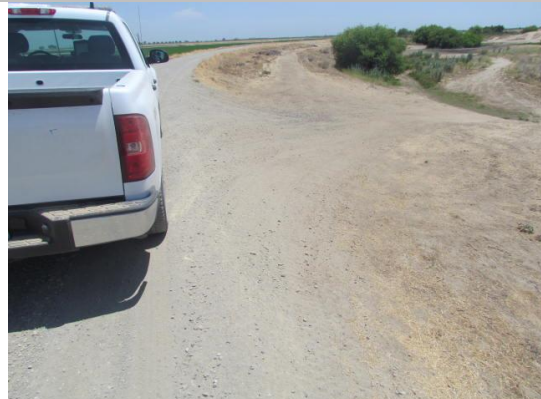
Photo 1 of 1 : FA_2015_NA0010_139_16_20150914_00015.jpg

LM Start	2.12	Rating **	A/W	Issue No.	16
LM End	2.42	Issue Type +	Ma	Location *	WS
Category	Earthen Levee			GPS Latitude/Longitude	
				Start	End
Item	Slope Stability			36.775507 °	36.774423 °
				-120.251672 °	-120.246993 °
DWR ID	DWR_NA0010_23_s_2013_16				
Action/Comments					
Repair the levee slope damaged by vehicle traffic and prevent access where possible.					
Inspector Comments: Several damaged sites within this reach. Damage caused by vehicle traffic.

Looking south at waterward slope damaged by vehicle traffic

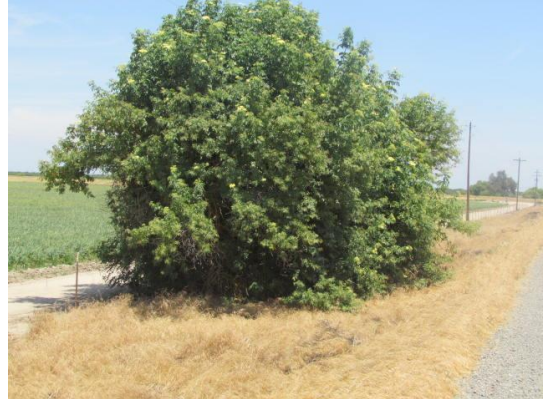
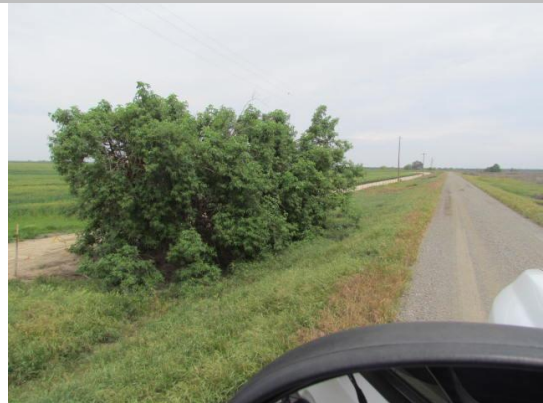
LM Start	2.85	Rating **	M	Issue No.	15
LM End	2.85	Issue Type +	Ma	Location *	LS
Category	Earthen Levee			GPS Latitude/Longitude	
				Start	End
Item	Vegetation			36.771537 °	36.771537 °
				-120.240917 °	-120.240917 °
DWR ID	DWR_NA0010_23_s_2012_15				
Action/Comments					
Elderberries are blocking visibility and flood fight capability. Inspector Comments: Control growth of elderberry bush on landward toe.

Looking south at elderberry at landward toe. (Spring 2015)

Looking south at elderberry on landside toe and berm. (Fall 2014)

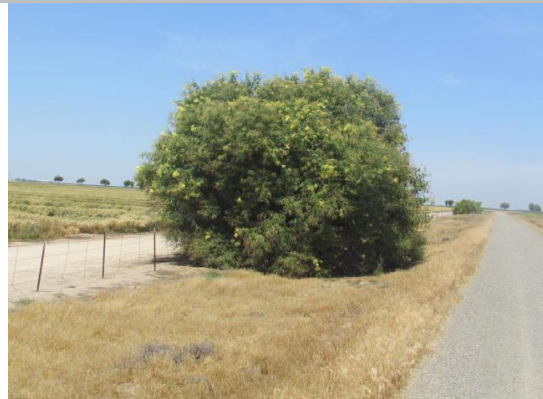
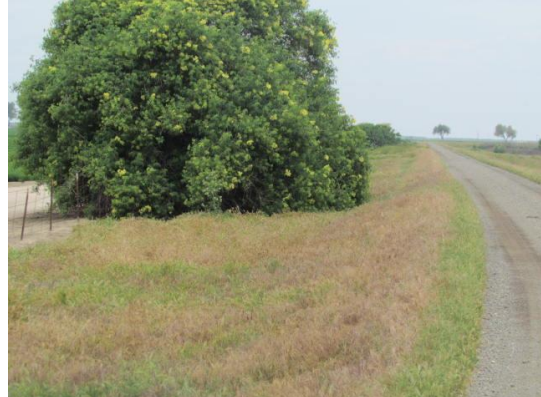
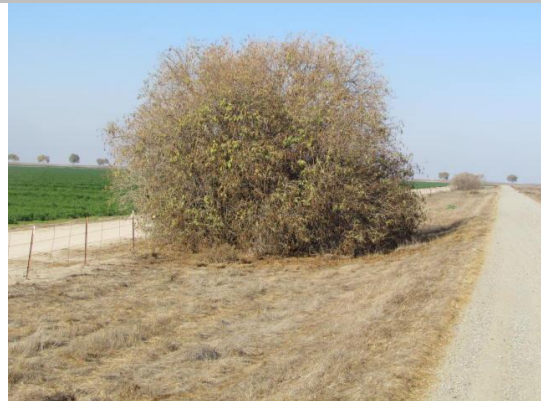
LM Start	3.30	Rating **	M	Issue No.	3
LM End	3.30	Issue Type +	Ma	Location *	LS
Category	Earthen Levee			GPS Latitude/Longitude	
				Start	End
Item	Vegetation			36.774403 °	36.774403 °
				-120.234705 °	-120.234705 °
DWR ID	DWR_NA0010_23_s_2012_3				
Action/Comments					
Elderberries are blocking visibility and flood fight capability. Inspector Comments: Control growth of elderberry on landward toe.

Looking south at elderberry on landward toe and berm. (Spring 2015)

Looking south at elderberry on landside toe and berm. (Fall 2014)

Looking south at elderberry bush on landward toe. (Spring 2013)

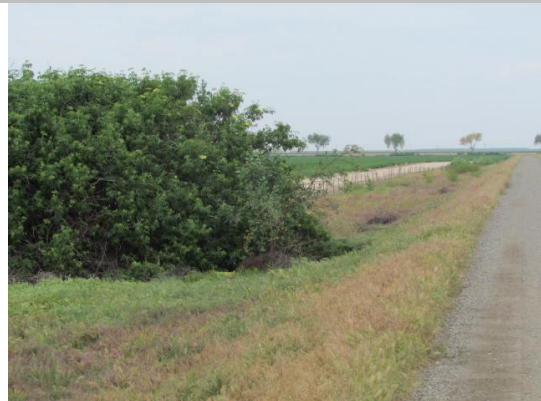
Photo 1 of 1 : FA_2015_NA0010_139_9_20150914_00006.jpg

LM Start	3.45	Rating **	M	Issue No.	9
LM End	3.45	Issue Type +	Ma	Location *	LS
Category	Earthen Levee			GPS Latitude/Longitude	
				Start	End
Item	Vegetation			36.776537 °	36.776537 °
				-120.234573 °	-120.234573 °
DWR ID	DWR_NA0010_23_s_2012_9				
Action/Comments					
Elderberries are blocking visibility and flood fight capability. Inspector Comments: Control growth of elderberry on landward toe and berm.

Looking south at elderberry on landside toe and berm.

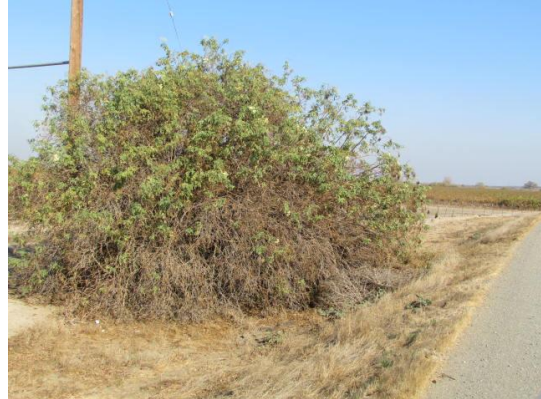
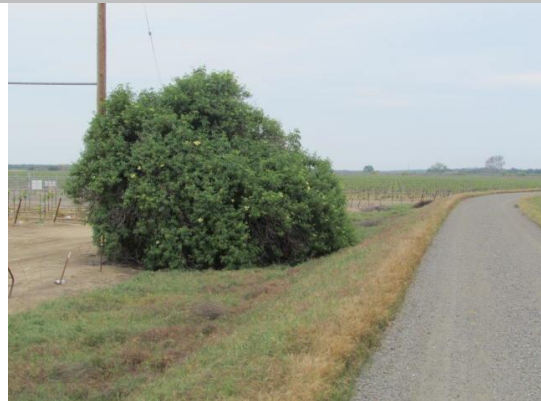
Looking south at elderberry bush on landward toe. (Fall 2013)

Looking south at elderberry on landside toe and berm.

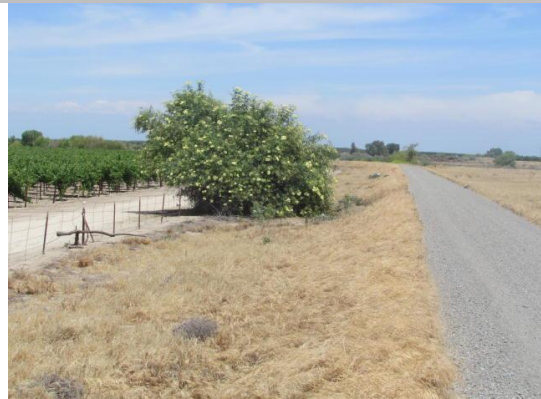
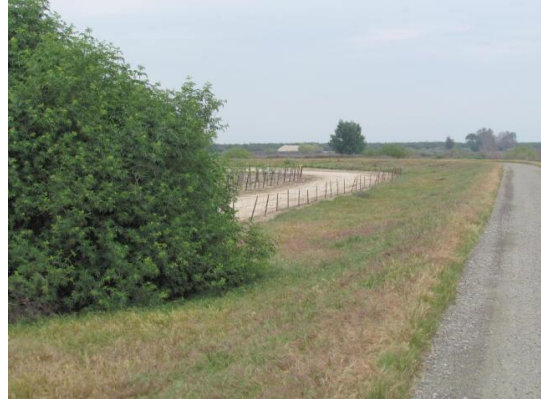
LM Start	4.45	Rating **	M	Issue No.	11
LM End	4.45	Issue Type +	Ma	Location *	LS
Category	Earthen Levee			GPS Latitude/Longitude	
				Start	End
Item	Vegetation			36.784523 °	36.784523
				-120.223292 °	-120.223292
DWR ID	DWR_NA0010_23_s_2012_11				
Action/Comments					
Elderberries are blocking visibility and flood fight capability. Inspector Comments: Control growth of elderberry on landward toe and berm.

Looking south at elderberry on landward toe and berm. (Spring 2015)

Looking south at elderberry on landside toe and berm.

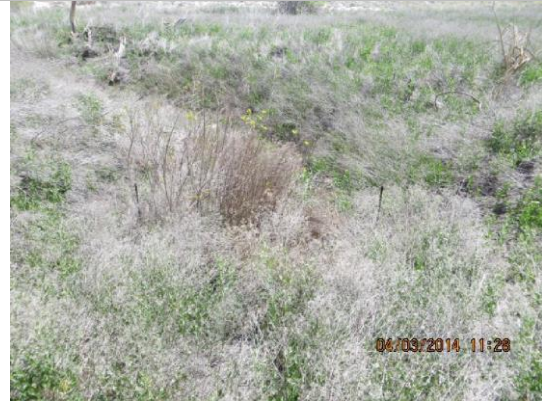
Photo 1 of 3 : UCIP_FA_2015_3708.jpg

Inspector Comments: FS_ID:39540
 DS_ID:19953
 EP_NO: N/A
 FS_HLM: 4.859
 Repair Type: Non-Urgent
 Crossing Status: Found
 UCIP Comments: Heavy vegetation at inlet and outlet--recommend clearing.
 FIELD_STRUCT_DESC: 30-inch square R.C.B.C. through the levee, 10.7 feet below the crown. Concrete "U" headwall on both ends. 4.5'X7' Concrete riser with slide gate on the waterward slope. Inlet channel cobble revetted 15.0 feet long.
 FS Date: 04/03/2014

Heavy vegetation in outlet/channel on WS toe.

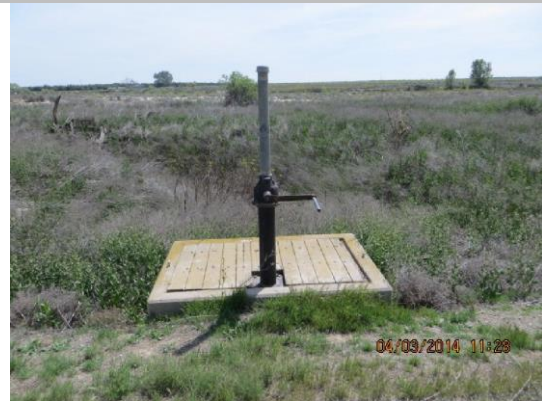
Photo 2 of 3 : UCIP_FA_2015_3709.jpg

Slide gate in concrete riser on WS shoulder.

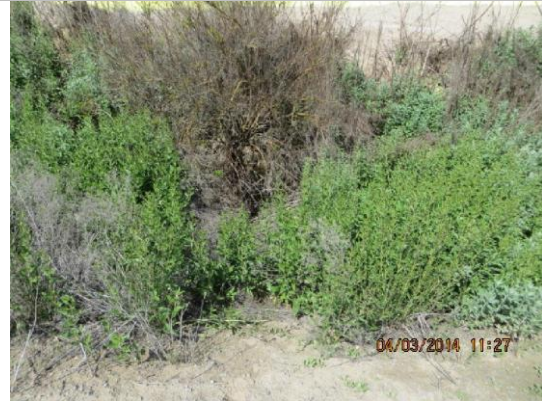
Photo 3 of 3 : UCIP_FA_2015_3710.jpg

Heavy vegetation at concrete inlet on LS toe.

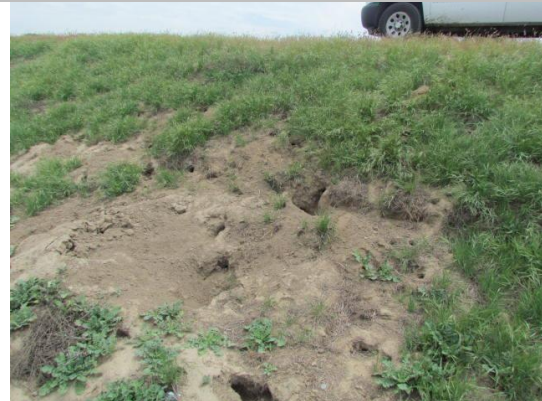
Photo 1 of 1 : FA_2015_NA0010_139_5_20150914_00004.jpg

LM Start	5.68	Rating **	U	Issue No.	5
LM End	5.68	Issue Type +	Ma	Location *	WS
Category	Earthen Levee			GPS Latitude/Longitude	
				Start	End
Item	Animal Control			36.791981 °	36.791981 °
				-120.206274 °	-120.206274 °
DWR ID	DWR_NA0010_23_s_2012_5				
Action/Comments					
Exterminate rodents and backfill and compact or grout burrows. Inspector Comments: Several large rodent holes in this area.

Looking at several rodent holes on landside slope.

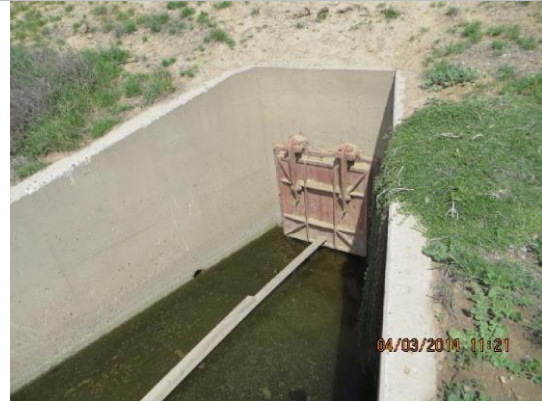
Photo 1 of 3 : UCIP_FA_2015_3590.jpg

Flapgate on Concrete headwall on WS toe.

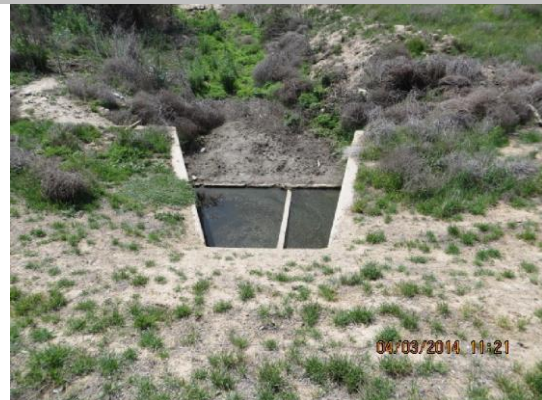
Photo 2 of 3 : UCIP_FA_2015_3591.jpg

Concrete headwall on WS toe.

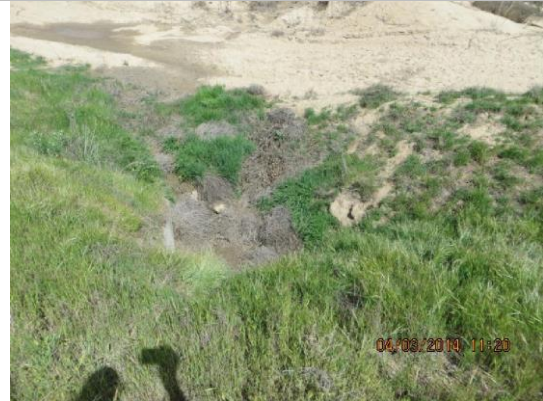
Photo 3 of 3 : UCIP_FA_2015_3707.jpg

Concrete headwall at LS toe.

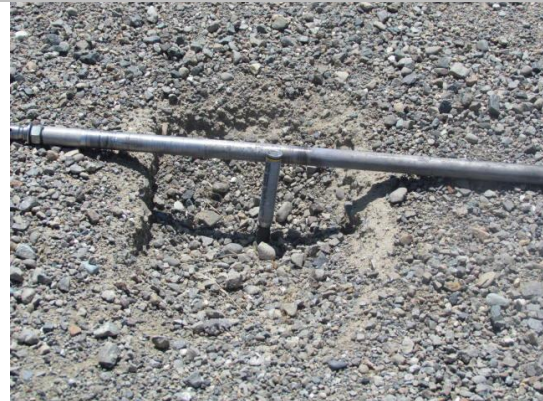
Photo 1 of 2 : FA_2015_NA0010_139_14_20150914_00011.jpg

LM Start	6.58	Rating **	A/W	Issue No.	14
LM End	6.58	Issue Type +	Ma	Location *	CR
Category	Earthen Levee			GPS Latitude/Longitude	
				Start	End
Item	Crown Surface / Depressions / Rutting			36.782020 °	36.782020 °
				-120.199789 °	-120.199789 °
DWR ID	DWR_NA0010_23_s_2015_14				
Action/Comments					
Repair depressions or ruts in the crown or slope. Inspector Comments: Two depressions greater than 3' on levee crown.

Looking at one of two depression on levee crown.

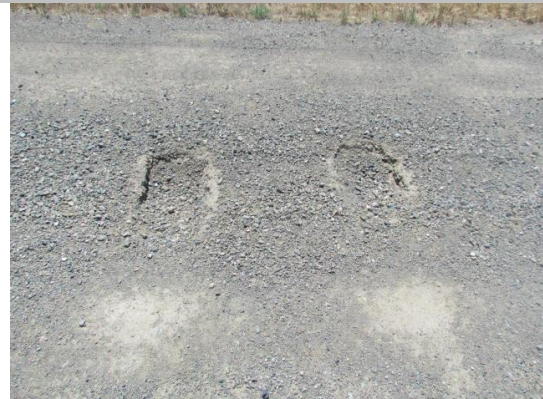
Photo 2 of 2 : FA_2015_NA0010_139_14_20150914_00012.jpg

Looking at two depression on levee crown.

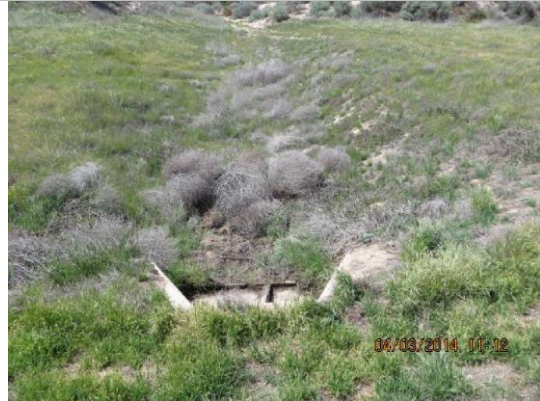
Photo 1 of 3 : UCIP_FA_2015_3587.jpg

Concrete headwall on WS toe.

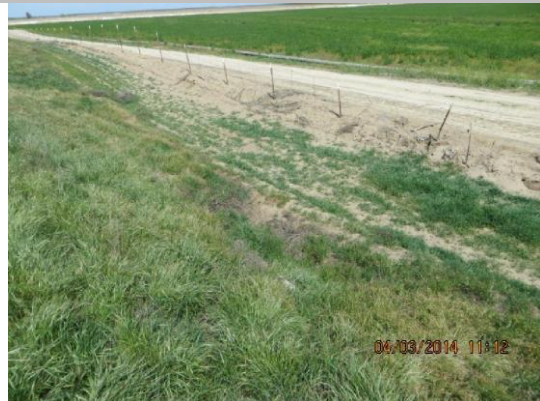
Photo 2 of 3 : UCIP_FA_2015_3588.jpg

Concrete headwall on LS toe.

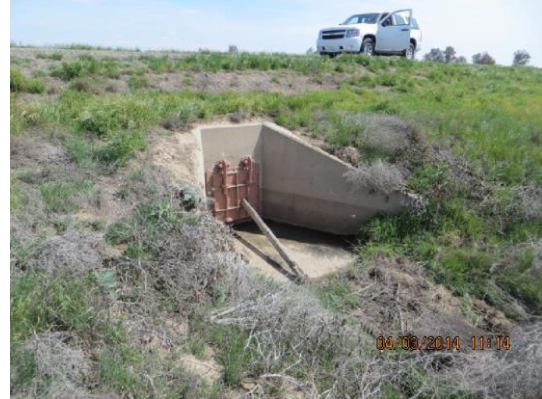
Photo 3 of 3 : UCIP_FA_2015_3589.jpg

Flapgate on Concrete headwall at WS toe.

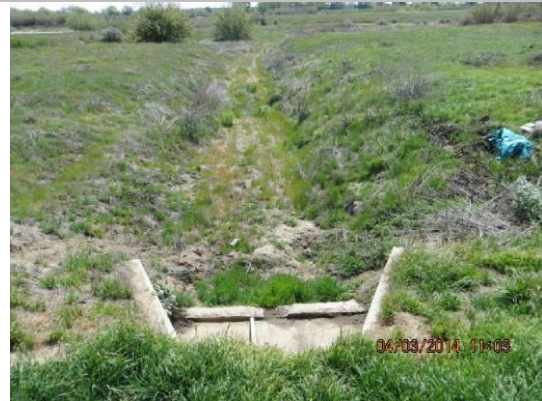
Photo 1 of 3 : UCIP_FA_2015_3584.jpg

cocrete headwall at drainage ditch on WS toe.

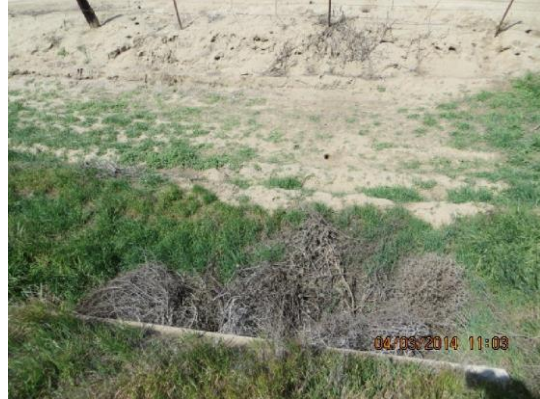
Photo 2 of 3 : UCIP_FA_2015_3585.jpg

Concrete headwall on LS toe.

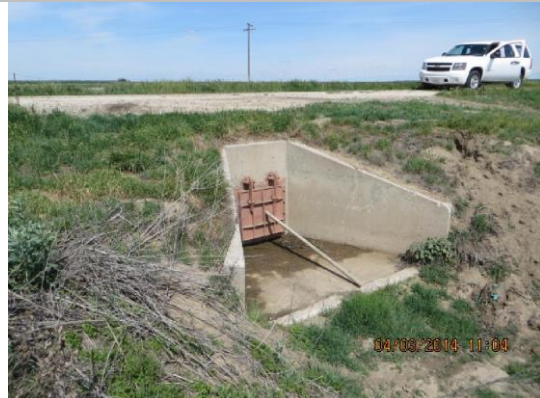
Photo 3 of 3 : UCIP_FA_2015_3586.jpg

Flapgate on WS toe.

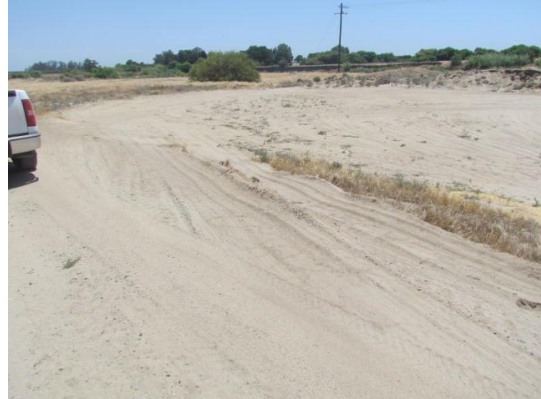
Photo 1 of 1 : FA_2015_NA0010_139_17_20150914_00016.jpg

LM Start	8.47	Rating **	A/W	Issue No.	17
LM End	8.47	Issue Type +	Ma	Location *	WS
Category	Earthen Levee			GPS Latitude/Longitude	
				Start	End
Item	Slope Stability			36.793717 °	36.793717 °
				-120.178997 °	-120.178997 °
DWR ID	DWR_NA0010_23_s_2015_17				
Action/Comments					
Repair the levee slope damaged by vehicle traffic and prevent access where possible.					
Inspector Comments: Waterward slope.

Looking southwest at waterward slope damaged due to vehicle traffic.

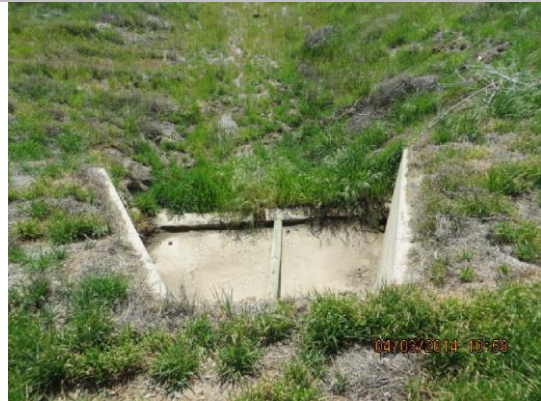
Photo 1 of 3 : UCIP_FA_2015_3581.jpg

Concrete headwall on WS toe.

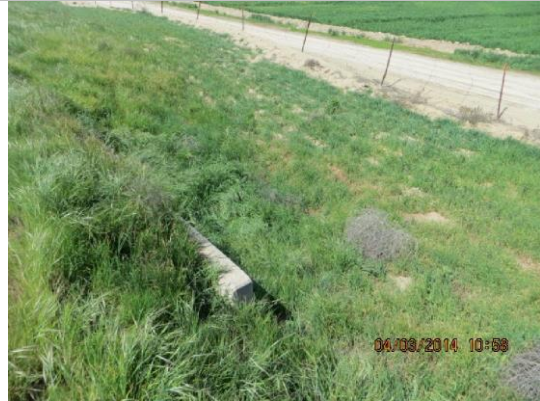
Photo 2 of 3 : UCIP_FA_2015_3582.jpg

Concrete headwall on LS toe.

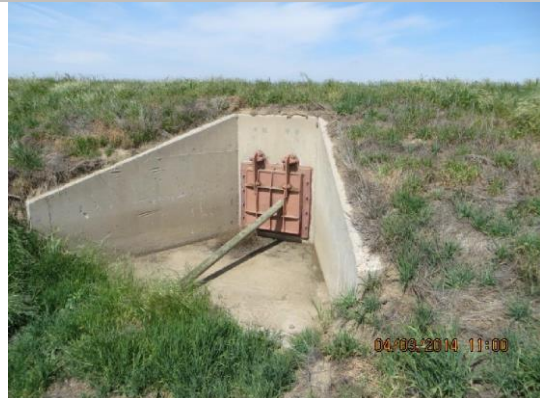
Photo 3 of 3 : UCIP_FA_2015_3583.jpg

Flapgate on Concrete headwall at WS toe.

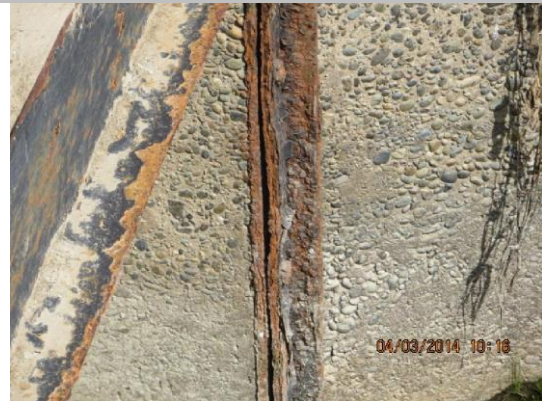
Photo 1 of 3 : UCIP_FA_2015_3578.jpg

LM Start	9.75	Rating **	U	Issue No.	38
LM End	9.75	Issue Type +	En	Location *	CR
Category	Supplemental			GPS Latitude/Longitude	
				Start	End
Item	DWR UCIP Field Study			36.807768 °	36.807768 °
				-120.168848 °	-120.168848 °
DWR ID					
Action/Comments					
Inspector Comments: FS_ID:33066					
DS_ID:19943					
EP_NO: N/A					
FS_HLM: 9.761					
Repair Type: Urgent					
Crossing Status: Found					
UCIP Comments: Slide gate not functional. Slide gate channels heavily corroded (exfoliated) and likely impact functionality/structural integrity of gate.					
FIELD_STRUCT_DESC: 1 of 2: 5.25 x 4 foot R.C.B.C. through the levee, 10.0 feet below the crown. Concrete "U" headwall on the waterward end. Gear pedestal slide gate with wall bracket on the waterward headwall. Concrete "U" headwall on the landward end. Outlet channel cobble revetted 10.0 feet long. Guard rails on both shoulders. Slide gates on waterward side. (USACE-1967). This entry matches the Drainage or Irrigation Structure referenced in O&M manual (HLM 9.76). [Gravelly Ford Canal Irrigation Structure]

Heavy corrosion in slide gate tracks on WS toe.

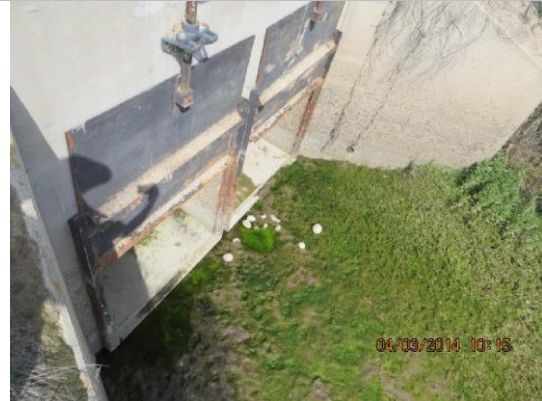
Photo 2 of 3 : UCIP_FA_2015_3579.jpg

Slide gate on concrete headwall at WS toe.

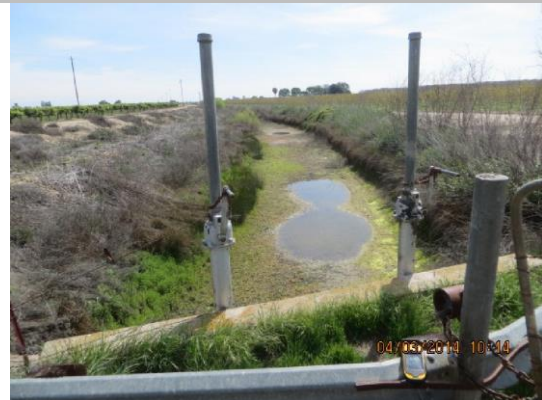
Photo 3 of 3 : UCIP_FA_2015_3580.jpg

Slide gate actuator visible on WS shoulder with concrete headwall.

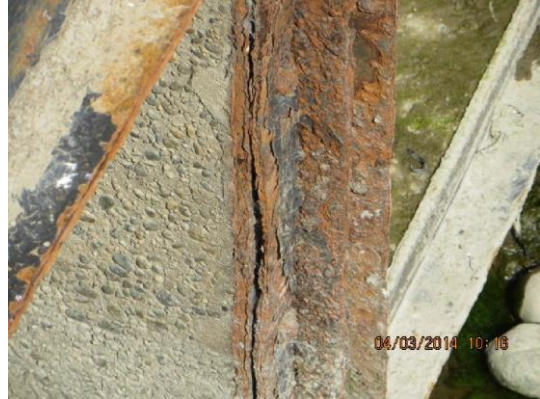
Photo 1 of 3 : UCIP_FA_2015_3575.jpg

LM Start	9.75	Rating **	U	Issue No.	39
LM End	9.75	Issue Type +	En	Location *	CR
Category	Supplemental			GPS Latitude/Longitude	
				Start	End
Item	DWR UCIP Field Study			36.807777 °	36.807777 °
				-120.168843 °	-120.168843 °
DWR ID					
Action/Comments					
Inspector Comments: FS_ID:33063					
DS_ID:19980					
EP_NO: N/A					
FS_HLM: 9.762					
Repair Type: Urgent					
Crossing Status: Found

Slide gate tracks show heavy corrosion impacting actuation of slide gate.

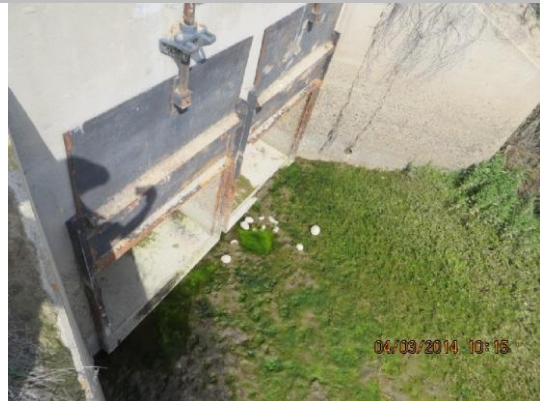
Photo 2 of 3 : UCIP_FA_2015_3576.jpg

Slide gates on WS toe.

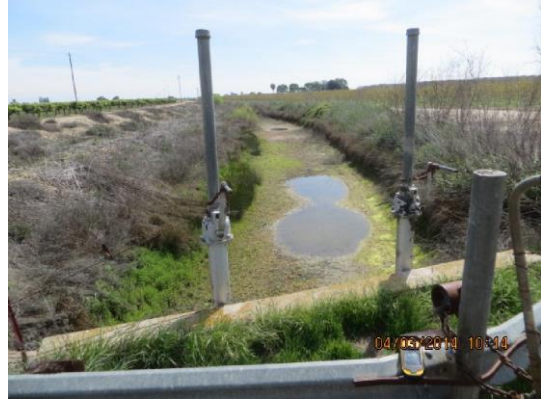
Photo 3 of 3 : UCIP_FA_2015_3577.jpg

Slide gate actuators on Concrete headwall at WS shoulder.

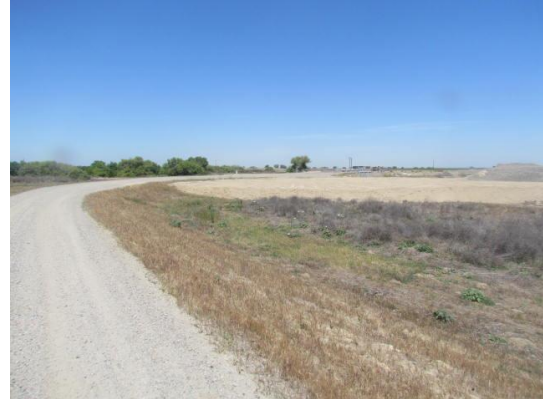
Photo 2 of 2 : FA_2015_NA0010_140_47_20150914_00008.jpg

LM Start	0.06	Rating **	M	Issue No.	47 (cont)
LM End	0.06	Issue Type +	En	Location *	LS
Category	Earthen Levee			GPS Latitude/Longitude	
				Start	End
Item	Encroachments			36.772328 °	36.772328 °
				-120.285117 °	-120.285117 °
DWR ID	DWR_NA0010_24_s_2014_47				
Action/Comments					
Material					
Inspector Comments: District constructed a berm on waterward slope.					
Berm is being used for staging of earthen material.

Looking north at berm on waterward slope.

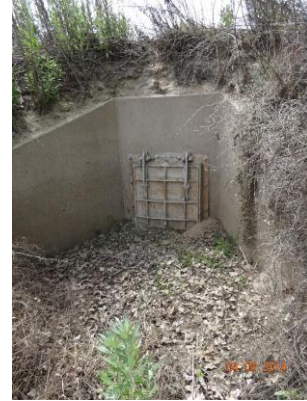
Photo 1 of 3 : UCIP_FA_2015_4074.jpg

Inspector Comments: FS_ID:33264
 DS_ID:19955
 EP_NO: N/A
 FS_HLM: 0.5
 Repair Type: Non-Urgent
 Crossing Status: Found
 UCIP Comments: No access available to confirm condition of landward side headwall. Recommend clearing debris along fence. Surface erosion near concrete headwall on landward side was present.
 FIELD_STRUCT_DESC: 30-inch square R.C.B.C. through the levee, 13.5 feet below the crown. Concrete headwalls on both ends. Flap gate on the waterward end.
 FS Date: 04/08/2014

Square gate visible on waterward side.
