**Flood Control Project Maintenance
Levee Inspections**

Fall 2015 Levee Maintenance Deficiency Summary Report

San Joaquin River Basin

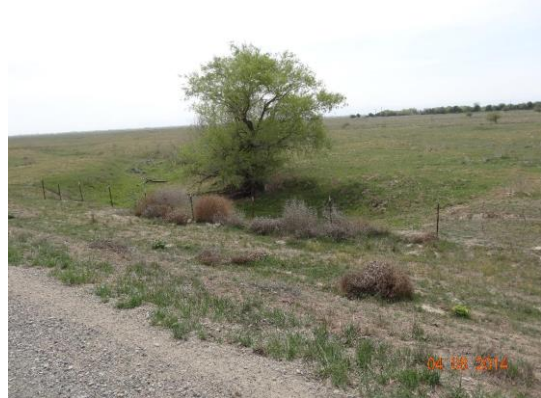
Photo 2 of 3 : UCIP_FA_2015_4075.jpg

View of landward side.

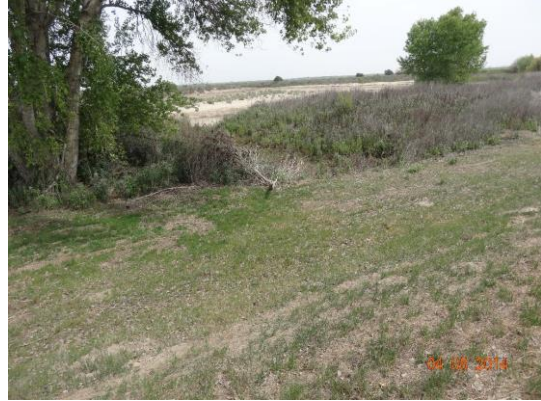
Photo 3 of 3 : UCIP_FA_2015_4076.jpg

View of waterward side.

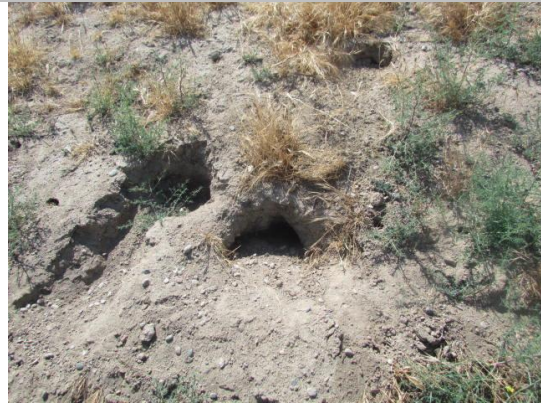
Photo 1 of 1 : FA_2015_NA0010_140_6_20150914_00004.jpg

LM Start	0.82	Rating **	M	Issue No.	6
LM End	0.82	Issue Type +	Ma	Location *	LS
Category	Earthen Levee			GPS Latitude/Longitude	
				Start	End
Item	Animal Control			36.766775 °	36.766775 °
				-120.278757 °	-120.278757 °
DWR ID	DWR_NA0010_24_s_2013_6				
Action/Comments					
Exterminate rodents and backfill and compact or grout burrows. Inspector Comments: Noted several rodent holes within this section.

Looking at several rodent holes on landward slope.

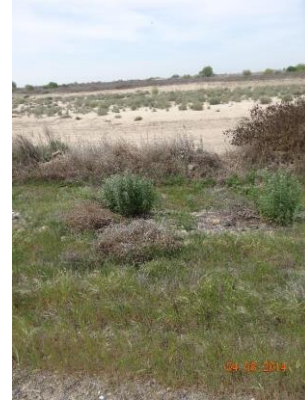
Photo 1 of 2 : UCIP_FA_2015_4077.jpg

Inspector Comments: FS_ID:33265
 DS_ID:19961
 EP_NO: 13735
 FS_HLM: 1.06
 Repair Type: Non-Urgent
 Crossing Status: Found
 UCIP Comments: Unable to determine status of crossing. Need to contact owner to determine status of crossing.
 FIELD_STRUCT_DESC: 24-inch steel discharge pipe through the levee, 2-feet below the crown. Roadway on crown has been padded 1-foot. Siphon breaker on the apex of pipeline on landward shoulder. Galvanized siphon vent pipe on the landward shoulder. Steel cutoff wall around the pipeline at centerline of levee. Pump on landward side. (Permit No. 13735-1984).
 FS Date: 04/08/2014

View of waterward side.

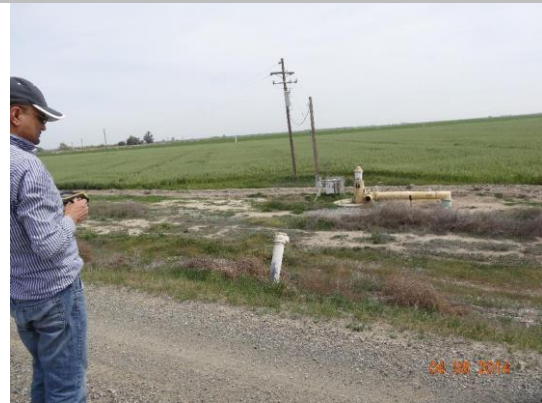
Photo 2 of 2 : UCIP_FA_2015_4078.jpg

View of landward side.

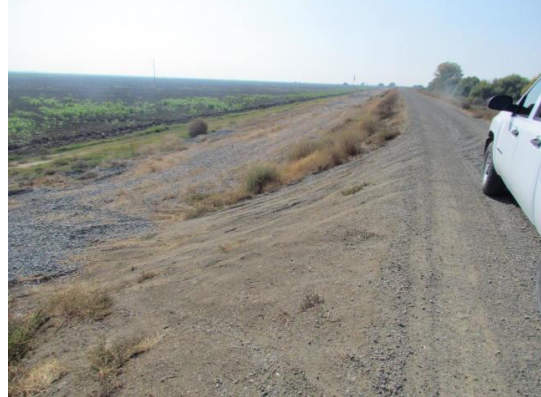
Photo 1 of 1 : FA_2015_NA0010_140_13_20150914_00006.jpg

LM Start	1.25	Rating **	A/W	Issue No.	13
LM End	1.25	Issue Type +	Ma	Location *	LS
Category	Earthen Levee			GPS Latitude/Longitude	
				Start	End
Item	Slope Stability			36.771834 °	36.771834
				-120.274224 °	-120.274224
DWR ID	DWR_NA0010_24_f_2014_13				
Action/Comments					
Repair the levee slope damaged by vehicle traffic and prevent access where possible.					
Inspector Comments: Slope damage due to vehicle traffic.

Looking north at slope damage by vehicle traffic on landward slope.

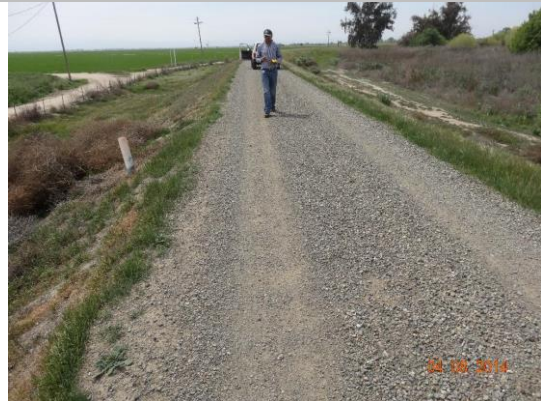
Photo 1 of 3 : UCIP_FA_2015_4079.jpg

LM Start	1.74	Rating **	M	Issue No.	271
LM End	1.74	Issue Type +	En	Location *	LS
Category	Supplemental			GPS Latitude/Longitude	
				Start	End
Item	DWR UCIP Field Study			36.771065 °	36.771065 °
				-120.266294 °	-120.266294 °
DWR ID					
Action/Comments					
Inspector Comments: FS_ID:33266					
DS_ID:19962					
EP_NO: 13085					
FS_HLM: 1.74					
Repair Type: Non-Urgent					
Crossing Status: Indicator Found					
UCIP Comments: Need to contact owner to determine status.					
FIELD_STRUCT_DESC: 20-inch steel discharge pipe through the					
levee, 2-feet below the crown. Siphon breaker installed on apex of pipe					
on the landward shoulder. Steel cutoff wall placed around pipeline at					
each shoulder. Pipeline encased through the levee crown in concrete.					
Vent pipe on landward side. Rock riprap on the waterward levee slope.					
(Permit No. 13085-1981).					
FS Date: 04/08/2014

Overview of levee crown at crossing.

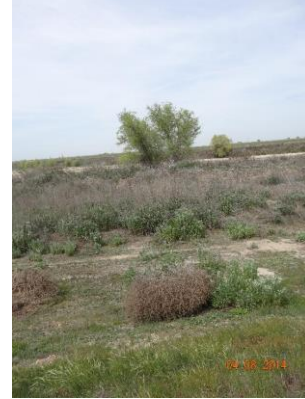
Photo 2 of 3 : UCIP_FA_2015_4080.jpg

Inspector Comments: FS_ID:33266
 DS_ID:19962
 EP_NO: 13085
 FS_HLM: 1.74
 Repair Type: Non-Urgent
 Crossing Status: Indicator Found
 UCIP Comments: Need to contact owner to determine status.
 FIELD_STRUCT_DESC: 20-inch steel discharge pipe through the levee, 2-feet below the crown. Siphon breaker installed on apex of pipe on the landward shoulder. Steel cutoff wall placed around pipeline at each shoulder. Pipeline encased through the levee crown in concrete. Vent pipe on landward side. Rock riprap on the waterward levee slope. (Permit No. 13085-1981).
 FS Date: 04/08/2014

View of waterward side.

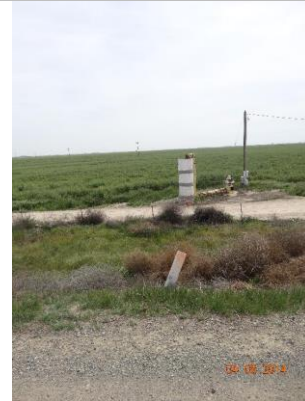
Photo 3 of 3 : UCIP_FA_2015_4081.jpg

View of landward side.

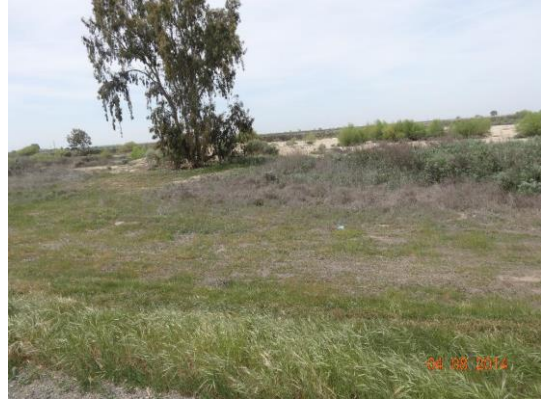
Photo 1 of 3 : UCIP_FA_2015_3557.jpg

View of waterward side.

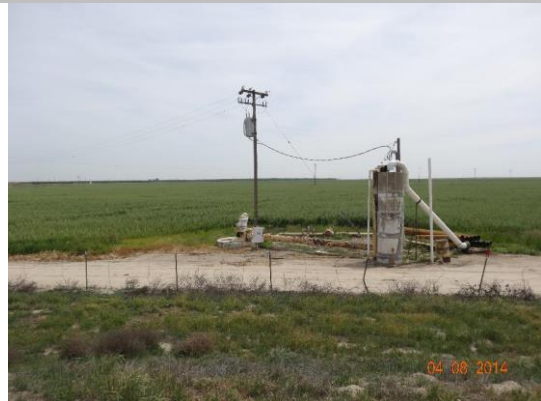
Photo 2 of 3 : UCIP_FA_2015_3558.jpg

View of landward side.

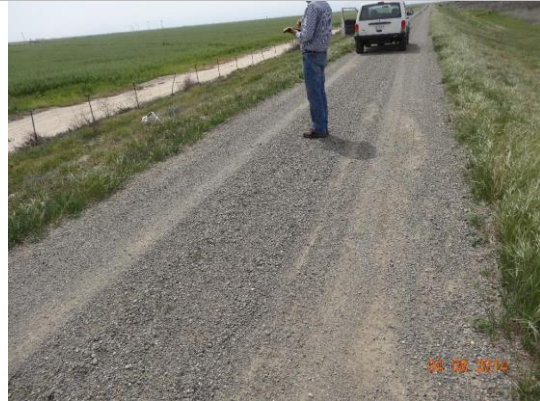
Photo 3 of 3 : UCIP_FA_2015_4082.jpg

Overview of levee crown at crossing.

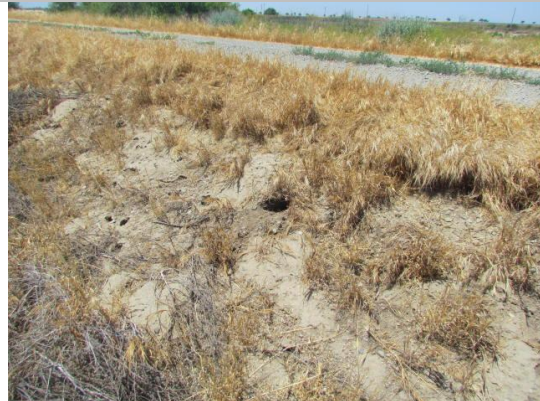
Photo 1 of 1 : FA_2015_NA0010_140_7_20150914_00005.jpg

LM Start	3.46	Rating **	M	Issue No.	7
LM End	3.46	Issue Type +	Ma	Location *	LS
Category	Earthen Levee			GPS Latitude/Longitude	
				Start	End
Item	Animal Control			36.769345 °	36.769345 °
				-120.238370 °	-120.238370 °
DWR ID	DWR_NA0010_24_s_2012_7				
Action/Comments					
No rodents visible, but rodent burrows visible; need to backfill and compact or grout burrows. Inspector Comments: One of several rodent holes on landward slope.

Looking east at one of several rodent holes on landward slope.

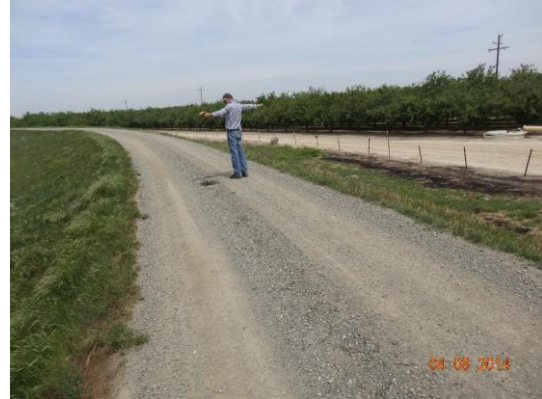
Photo 1 of 3 : UCIP_FA_2015_4353.jpg

Inspector Comments: FS_ID:36849
 DS_ID:19964
 EP_NO: N/A
 FS_HLM: 4.05
 Repair Type: Non-Urgent
 Crossing Status: Found
 UCIP Comments: Unable to confirm crossing alignment and appurtenances associated with this crossing. Multiple stand pipes visible on landward side. Need to contact owner to determine status of crossing and alignment.
 FIELD_STRUCT_DESC: 30-inch square R.C.B.C. through the levee 12.5 feet below the crown. Concrete riser unit with slide gate on the waterward slope. Screw gate on landward shoulder. Pump on landward side. Rehabilitation of crossing under Permit No. 13085 (1981).
 FS Date: 04/08/2014

Overview of levee at crossing.

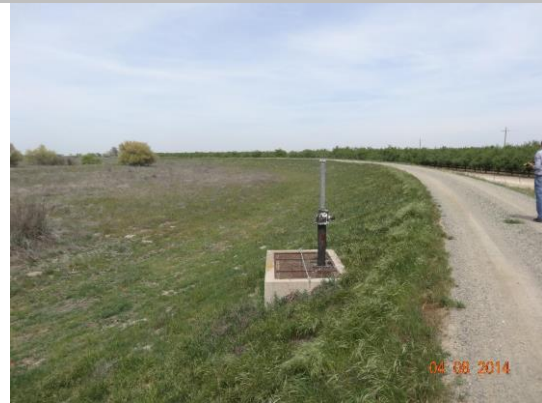
Photo 2 of 3 : UCIP_FA_2015_4354.jpg

Slide gate inside concrete box located on waterward side.

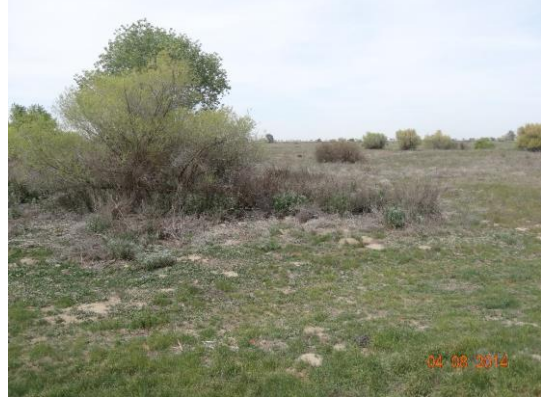
Photo 3 of 3 : UCIP_FA_2015_4355.jpg

View of waterwar side.

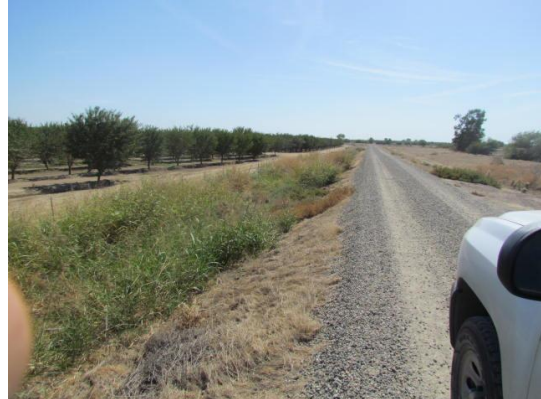
Photo 1 of 2 : FA_2015_NA0010_140_268_20151014_00011.jpg

LM Start	4.50	Rating **	M	Issue No.	268
LM End	4.52	Issue Type +	Ma	Location *	LS
Category	Earthen Levee			GPS Latitude/Longitude	
				Start	End
Item	Vegetation			36.775118 °	36.775466 °
				-120.231114 °	-120.231202 °
DWR ID	DWR_NA0010_24_s_2015_268				
Action/Comments					
Remove the wild growth other than native grasses from the levee slopes. Inspector Comments: Control Johnson Grass on landward toe and berm.

Looking south at Johnson Grass at landward toe and berm. Fall 2015

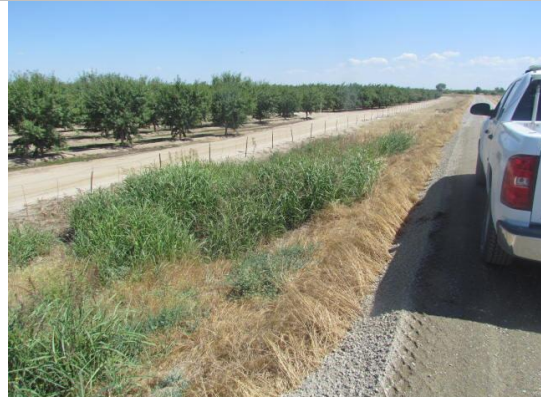
Photo 2 of 2 : FA_2015_NA0010_140_268_20150914_00010.jpg

Looking south at Johnson Grass at landward toe and berm. Spring 2015

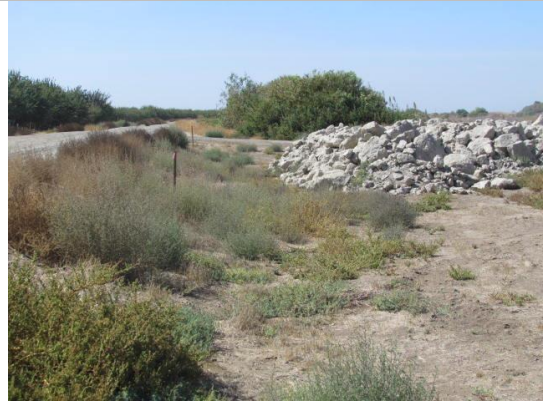
Photo 1 of 2 : FA_2015_NA0010_140_266_20151014_00012.jpg

LM Start	5.40	Rating **	M	Issue No.	266
LM End	5.40	Issue Type +	En	Location *	WS
Category	Earthen Levee			GPS Latitude/Longitude	
				Start	End
Item	Encroachments			36.782405 °	36.782405 °
				-120.222763 °	-120.222763 °
DWR ID	DWR_NA0010_24_s _ 2015_266				
Action/Comments					
Material					
Inspector Comments: Rocks stockpile near waterward toe.

Looking at rock stockpile on waterward berm. Fall 2015

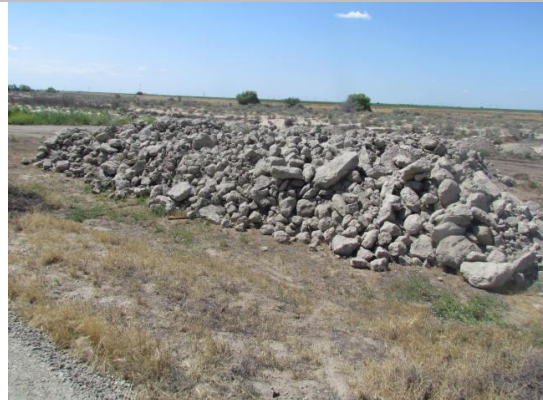
Photo 2 of 2 : FA_2015_NA0010_140_266_20150914_00009.jpg

Looking north at rock pile on waterward berm.

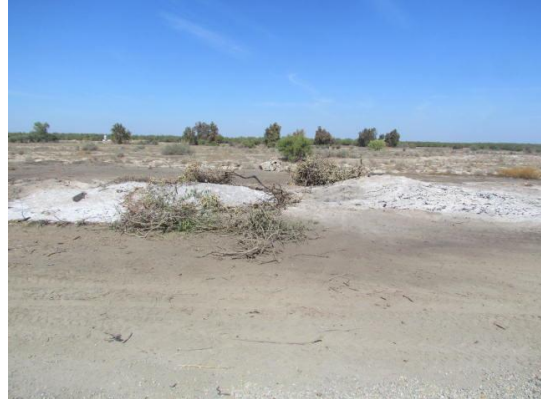
Photo 1 of 4 : FA_2015_NA0010_140_3_20151014_00013.jpg

Looking at burned pruning piles on waterward berm. Fall 2015

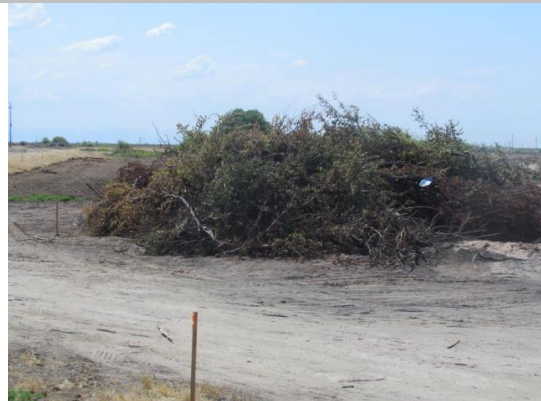
Photo 2 of 4 : FA_2015_NA0010_140_3_20150914_00001.jpg

Looking northeast at pruning pile on waterward berm. (Spring 2015)

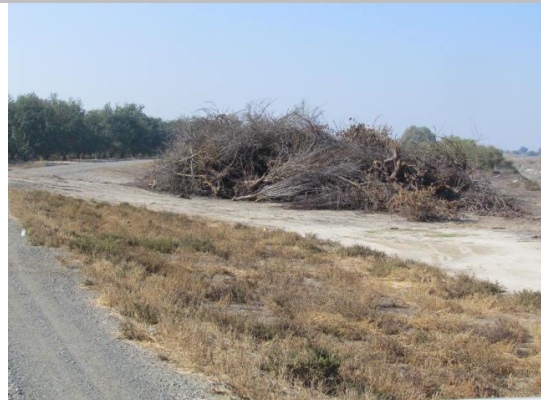
Photo 3 of 4 : FA_2015_NA0010_140_3_20150914_00002.jpg

Looking north at large pruning pile in channel. (Spring 2014)

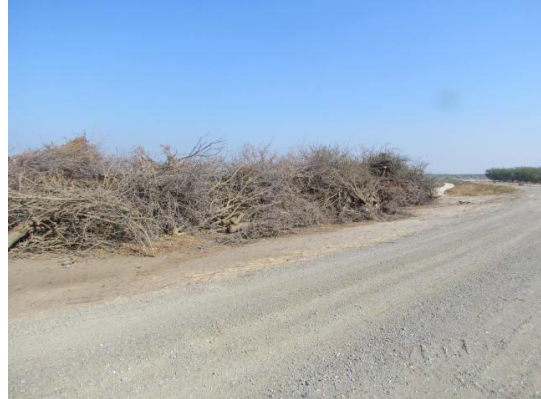
Photo 4 of 4 : FA_2015_NA0010_140_3_20150914_00003.jpg

LM Start	6.33	Rating **	A/W	Issue No.	3 (cont)	
LM End	6.33	Issue Type +	Ma	Location *	WS	
Category	Earthen Levee			GPS Latitude/Longitude		
				Start		End
Item	Encroachments			36.788155 °		36.788155 °
				-120.209655 °		-120.209655 °
DWR ID	DWR_NA0010_24_s_2012_3					
Action/Comments						
Prunings						
Inspector Comments: Large pruning pile in channel.

Looking south at large pruning pile in channel. (Spring 2013)

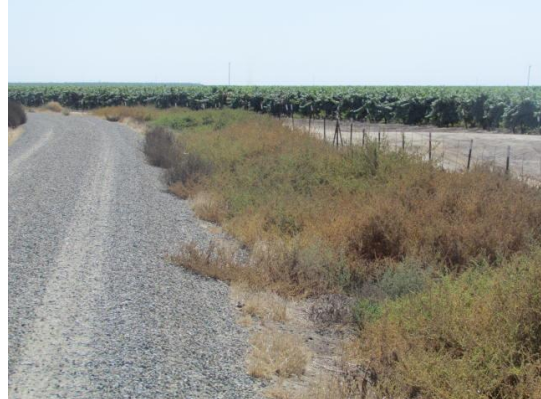
Photo 1 of 1 : FA_2015_NA0010_140_15_20151014_00014.jpg

LM Start	6.72	Rating **	U	Issue No.	15
LM End	6.91	Issue Type +	Ma	Location *	LS
Category	Earthen Levee			GPS Latitude/Longitude	
				Start	End
Item	Vegetation			36.786678 °	36.783993 °
				-120.204741 °	-120.203779 °
DWR ID	DWR_NA0010_24_f_2015_15				
Action/Comments					
Remove the wild growth other than native grasses from the levee slopes.					
Inspector Comments: Dense vegetation on landward slope

Looking at dense vegetation on landward slope.

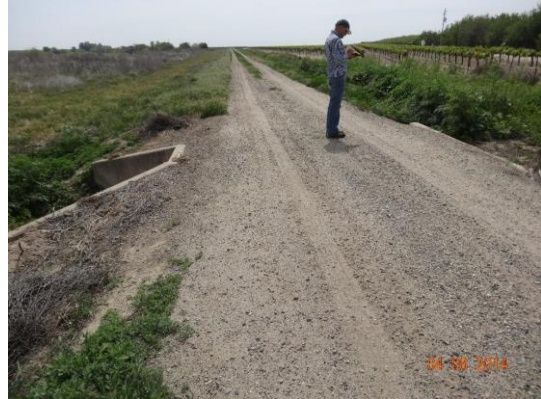
Photo 1 of 3 : UCIP_FA_2015_3597.jpg

Inspector Comments: FS_ID:42933
 DS_ID:19957
 EP_NO: N/A
 FS_HLM: 6.72
 Repair Type: Urgent
 Crossing Status: Found
 UCIP Comments: Unauthorized PVC pipe through existng crossing.
 PVC distorted inside--Need to contact owner to correct issue. If crossing was allowed need to contact owner for permit number issue for crossing variance.
 FIELD_STRUCT_DESC: 24-inch CM pipe through the levee, 3.6 feet below the crown. Concrete "U" headwall on the waterward end. Flap gate on the waterward end. Concrete headwall on the landward end.
 FS Date: 04/08/2014

Overview of levee crown at crossing.

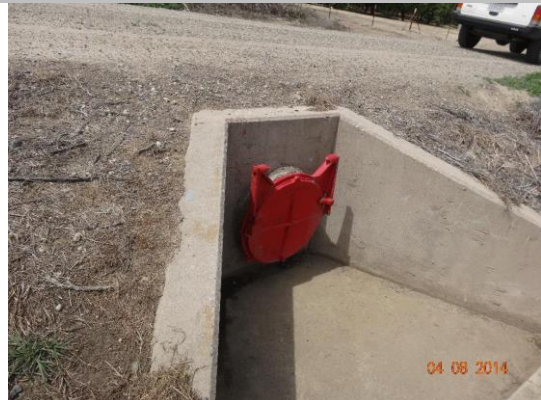
Photo 2 of 3 : UCIP_FA_2015_3598.jpg

Flap gate visible on waterward side.

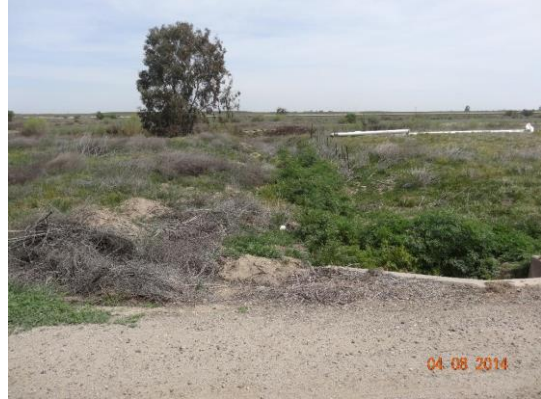
Photo 3 of 3 : UCIP_FA_2015_3599.jpg

View of waterward side--debris (pipe sections) located on waterward side.

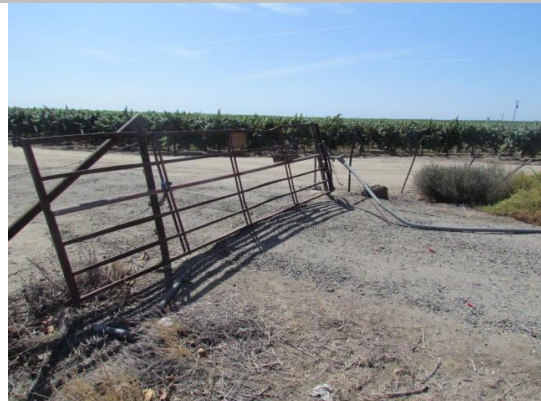
Photo 1 of 1 : FA_2015_NA0010_140_14_20151014_00015.jpg

LM Start	7.34	Rating **	M	Issue No.	14
LM End	7.34	Issue Type +	En	Location *	CR
Category	Earthen Levee			GPS Latitude/Longitude	
				Start	End
Item	Encroachments			36.779377 °	36.779377 °
				-120.198956 °	-120.198956 °
DWR ID	DWR_NA0010_24_f_2015_14				
Action/Comments					
Fence					
Inspector Comments: Repair gate.

Looking at gate at LM 7.34

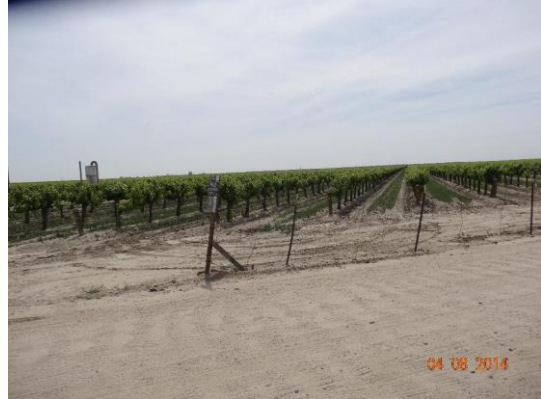
Photo 1 of 2 : UCIP_FA_2015_3716.jpg

View of landward side.

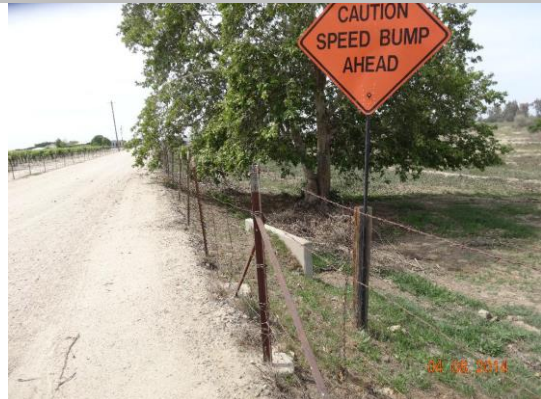
Photo 2 of 2 : UCIP_FA_2015_3717.jpg

LM Start	8.33	Rating **	M	Issue No.	275
LM End	8.33	Issue Type +	En	Location *	CR
Category	Supplemental			GPS Latitude/Longitude	
				Start	End
Item	DWR UCIP Field Study			36.778084 °	36.778084 °
				-120.184454 °	-120.184454 °
DWR ID					
Action/Comments					
Inspector Comments: FS_ID:33272					
DS_ID:19960					
EP_NO: N/A					
FS_HLM: 8.32					
Repair Type: Non-Urgent					
Crossing Status: Found					
UCIP Comments: Barbed wire along levee shoulder--no access. Need to confirm crossing size and condition of crossing.					
FIELD_STRUCT_DESC: 12-inch concrete pipe through the levee, 3.0 feet below the crown. Concrete headwall on the waterward end. Flap gate on the waterward end. (USACE-1967). This entry matches the Drainage or Irrigation Structure referenced in O&M manual (HLM 8.32).					
FS Date: 04/08/2014

View of waterward side.

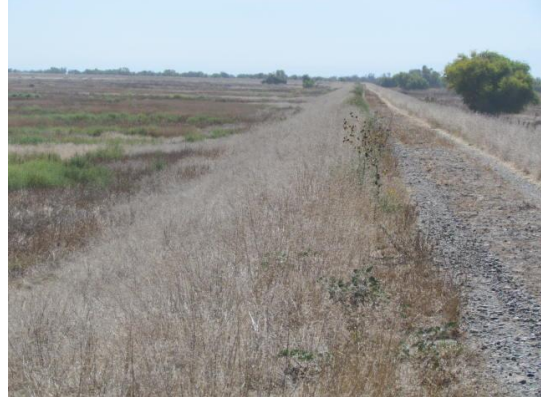
Photo 1 of 1 : FA_2015_NA0010_141_7_20151014_00003.jpg

LM Start	0.00	Rating **	M	Issue No.	7
LM End	2.48	Issue Type +	Ma	Location *	LS
Category	Earthen Levee			GPS Latitude/Longitude	
				Start	End
Item	Vegetation			37.296261 °	37.271165 °
				-120.880678 °	-120.866629 °
DWR ID	DWR_NA0010_25_f _ 2015_7				
Action/Comments					
Remove the wild growth other than native grasses from the levee slopes.

Looking at typical view of landward slope.

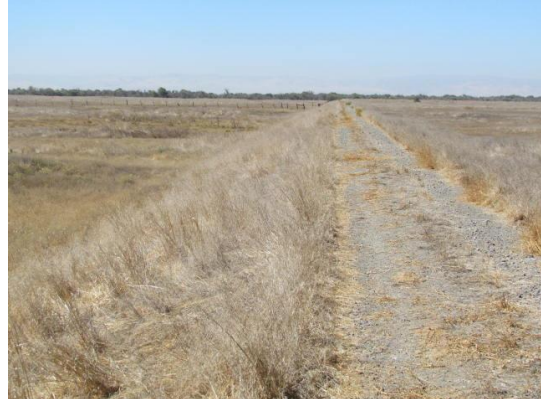
Photo 1 of 1 : FA_2015_NA0010_141_9_20151014_00002.jpg

LM Start	0.00	Rating **	M	Issue No.	9
LM End	2.48	Issue Type +	Ma	Location *	WS
Category	Earthen Levee			GPS Latitude/Longitude	
				Start	End
Item	Vegetation			37.296261 °	37.271165 °
				-120.880678 °	-120.866629 °
DWR ID	DWR_NA0010_25_f_2015_9				
Action/Comments					
Remove the wild growth other than native grasses from the levee slopes.

Looking at typical view of waterward slope.

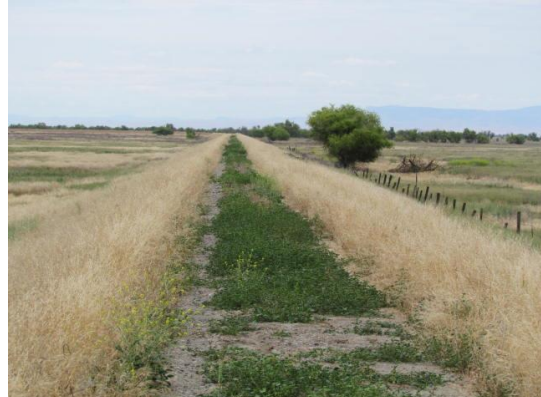
Photo 1 of 1 : FA_2015_NA0010_141_8_20150914_00001.jpg

LM Start	0.01	Rating **	M	Issue No.	8
LM End	2.48	Issue Type +	Ma	Location *	CR
Category	Earthen Levee			GPS Latitude/Longitude	
				Start	End
Item	Crown Surface / Depressions / Rutting			37.296117 °	37.271193 °
				-120.880724 °	-120.866633 °
DWR ID	DWR_NA0010_25_s_2012_8				
Action/Comments					
Add appropriate material and re-grade the levee to bring the crown above the design elevation.					
Inspector Comments: Control weeds on levee crown.

Looking north at growth on levee crown.

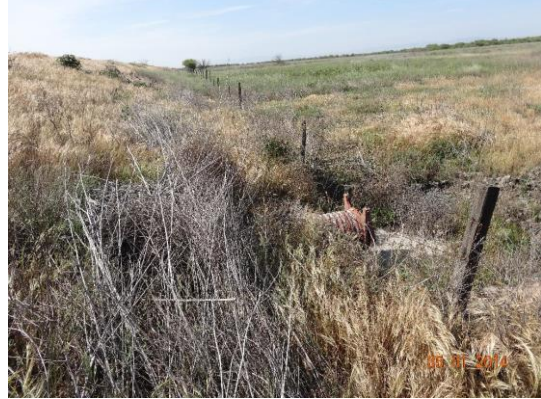
Photo 1 of 3 : UCIP_FA_2015_4356.jpg

LM Start	0.02	Rating **	M	Issue No.	10
LM End	0.02	Issue Type +	En	Location *	CR
Category	Supplemental			GPS Latitude/Longitude	
				Start	End
Item	DWR UCIP Field Study			37.296038 °	37.296038 °
				-120.880742 °	-120.880742 °
DWR ID					
Action/Comments					
Inspector Comments: FS_ID:39501 DS_ID:19965 EP_NO: N/A FS_HLM: 0 Repair Type: Non-Urgent Crossing Status: Found UCIP Comments: Dense vegetation limits the inspectors visibility to identify signs of pipe failure (leaks) along the slope. Recommend removing vegetation along pipe alignment to conduct proper inspection of structure. Sediment buildup in pipe visible from landward side--recommend clearing. FIELD_STRUCT_DESC: 24-inch CM pipe through the levee, 10.0 feet below the crown. Flap gate on the waterward end. (USACE-1967). This entry matches the Drainage or Irrigation Structure referenced in O&M manual (HLM 0.02). FS Date: 05/01/2014

Pipe daylight visible on waterward toe.

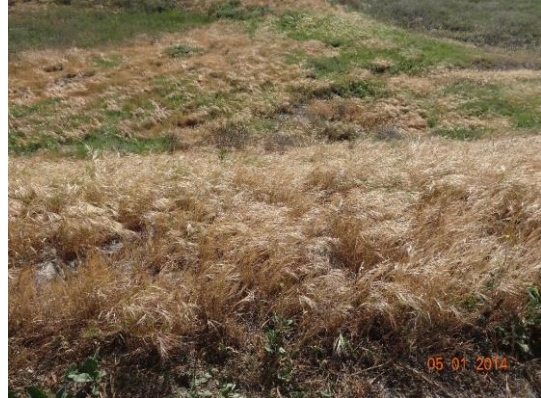
Photo 2 of 3 : UCIP_FA_2015_4357.jpg

View of landward side--dense vegetation on landward side.

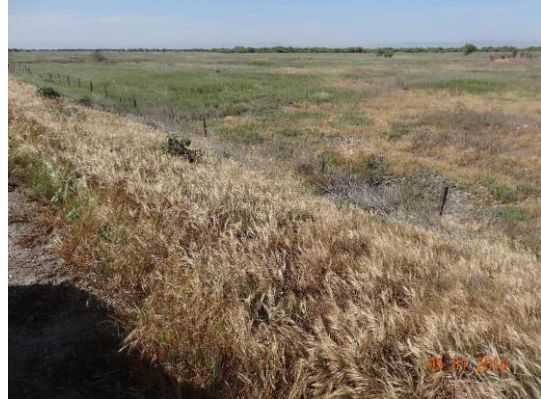
Photo 3 of 3 : UCIP_FA_2015_4358.jpg

LM Start	0.02	Rating **	M	Issue No.	10 (cont)
LM End	0.02	Issue Type +	En	Location *	CR
Category	Supplemental			GPS Latitude/Longitude	
				Start	End
Item	DWR UCIP Field Study			37.296038 °	37.296038 °
				-120.880742 °	-120.880742 °
DWR ID					
Action/Comments					
Inspector Comments: FS_ID:39501 DS_ID:19965 EP_NO: N/A FS_HLM: 0 Repair Type: Non-Urgent Crossing Status: Found

View of waterward side--dense vegetation on waterward side.

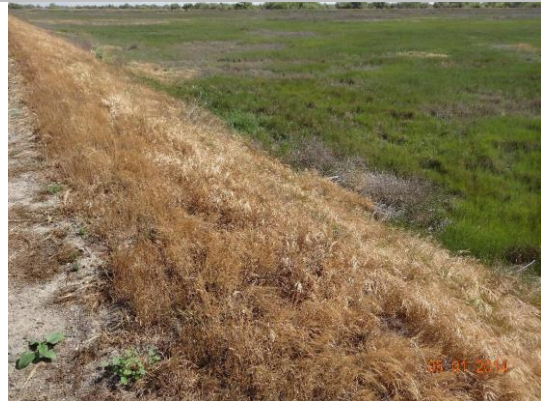
Photo 1 of 3 : UCIP_FA_2015_4959.jpg

LM Start	0.36	Rating **	M	Issue No.	11
LM End	0.36	Issue Type +	En	Location *	CR
Category	Supplemental			GPS Latitude/Longitude	
				Start	End
Item	DWR UCIP Field Study			37.291173 °	37.291173 °
				-120.880731 °	-120.880731 °
DWR ID					
Action/Comments					
Inspector Comments: FS_ID:36851 DS_ID:19966 EP_NO: N/A FS_HLM: 0.34 Repair Type: Non-Urgent Crossing Status: Found UCIP Comments: Dense vegetation limits the inspectors visibility to identify signs of pipe failure (leaks) along the slope. Recommend removing vegetation along pipe alignment to conduct proper inspection of structure. FIELD_STRUCT_DESC: 24-inch CM pipe through the levee, 11.6 feet below the crown. Flap gate on the waterward end. (USACE-1967). This entry matches the Drainage or Irrigation Structure referenced in O&M manual (HLM 0.35). FS Date: 05/01/2014

View of landward side.

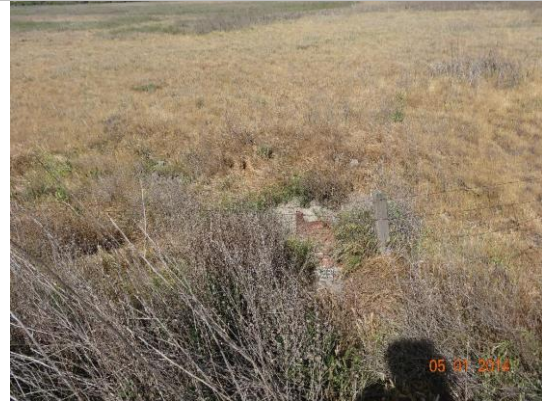
Photo 2 of 3 : UCIP_FA_2015_4960.jpg

Inspector Comments: FS_ID:36851
 DS_ID:19966
 EP_NO: N/A
 FS_HLM: 0.34
 Repair Type: Non-Urgent
 Crossing Status: Found
 UCIP Comments: Dense vegetation limits the inspectors visibility to identify signs of pipe failure (leaks) along the slope. Recommend removing vegetation along pipe alignment to conduct proper inspection of structure.
 FIELD_STRUCT_DESC: 24-inch CM pipe through the levee, 11.6 feet below the crown. Flap gate on the waterward end. (USACE-1967). This entry matches the Drainage or Irrigation Structure referenced in O&M manual (HLM 0.35).
 FS Date: 05/01/2014

Pipe outlet visible on waterward side.

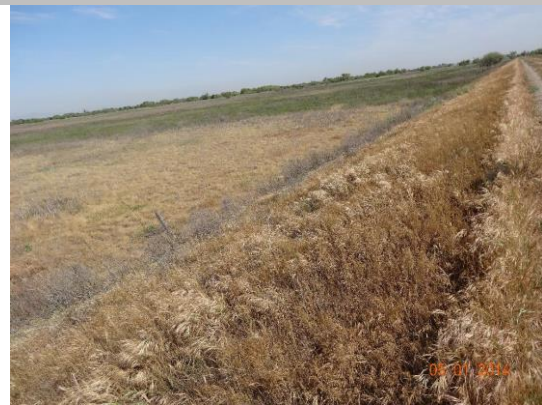
Photo 3 of 3 : UCIP_FA_2015_4961.jpg

View of waterward side.

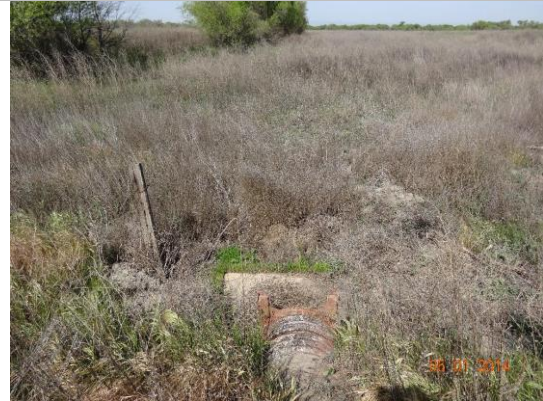
Photo 1 of 3 : UCIP_FA_2015_3208.jpg

LM Start	0.59	Rating **	M	Issue No.	12
LM End	0.59	Issue Type +	En	Location *	CR
Category	Supplemental			GPS Latitude/Longitude	
				Start	End
Item	DWR UCIP Field Study			37.287744 °	37.287744 °
				-120.880645 °	-120.880645 °
DWR ID					
Action/Comments					
Inspector Comments: FS_ID:36852					
DS_ID:19967					
EP_NO: N/A					
FS_HLM: 0.58					
Repair Type: Non-Urgent					
Crossing Status: Found

Pipe and flap gate visible on waterward side.

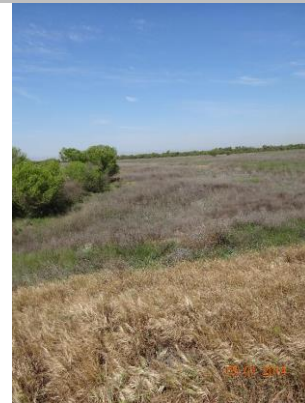
Photo 2 of 3 : UCIP_FA_2015_4962.jpg

Overview of waterward side--Salt Slough.

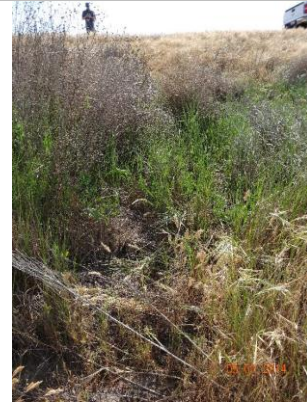
Photo 3 of 3 : UCIP_FA_2015_4963.jpg

LM Start	0.59	Rating **	M	Issue No.	12 (cont)
LM End	0.59	Issue Type +	En	Location *	CR
Category	Supplemental			GPS Latitude/Longitude	
				Start	End
Item	DWR UCIP Field Study			37.287744 °	37.287744 °
				-120.880645 °	-120.880645 °
DWR ID					
Action/Comments					
Inspector Comments: FS_ID:36852					
DS_ID:19967					
EP_NO: N/A					
FS_HLM: 0.58					
Repair Type: Non-Urgent					
Crossing Status: Found

View of waterward slope covered by dense vegetation.

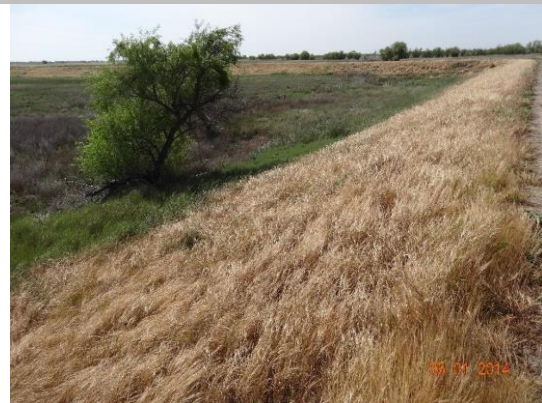
Photo 1 of 3 : UCIP_FA_2015_3209.jpg

LM Start	0.97	Rating **	M	Issue No.	13
LM End	0.97	Issue Type +	En	Location *	CR
Category	Supplemental			GPS Latitude/Longitude	
				Start	End
Item	DWR UCIP Field Study			37.282252 °	37.282252
				-120.880738 °	-120.880738
DWR ID					
Action/Comments					
Inspector Comments: FS_ID:36853 DS_ID:19968 EP_NO: N/A FS_HLM: 0.963 Repair Type: Non-Urgent Crossing Status: Found UCIP Comments: Dense vegetation limits the inspectors visibility to identify signs of pipe failure (leaks) along the slope. Recommend removing vegetation along pipe alignment to conduct proper inspection of structure. FIELD_STRUCT_DESC: 24-inch CM pipe through the levee, 11.4 feet below the crown. Flap gate on the waterward end. (USACE-1967). This entry matches the Drainage or Irrigation Structure referenced in O&M manual (HLM 0.97). FS Date: 05/01/2014

View of landward side.

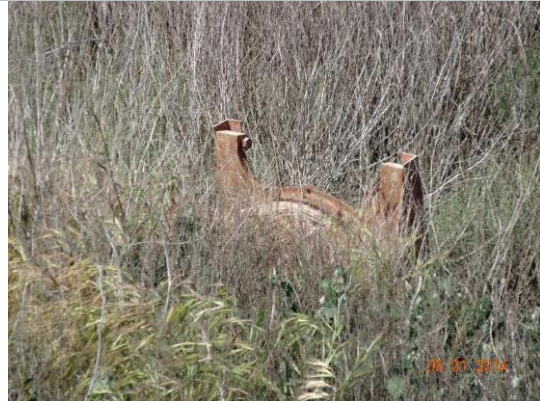
Photo 2 of 3 : UCIP_FA_2015_4973.jpg

Inspector Comments: FS_ID:36853
 DS_ID:19968
 EP_NO: N/A
 FS_HLM: 0.963
 Repair Type: Non-Urgent
 Crossing Status: Found
 UCIP Comments: Dense vegetation limits the inspectors visibility to identify signs of pipe failure (leaks) along the slope. Recommend removing vegetation along pipe alignment to conduct proper inspection of structure.
 FIELD_STRUCT_DESC: 24-inch CM pipe through the levee, 11.4 feet below the crown. Flap gate on the waterward end. (USACE-1967). This entry matches the Drainage or Irrigation Structure referenced in O&M manual (HLM 0.97).
 FS Date: 05/01/2014

Pipe and evidence of flap gate visible on waterward side.

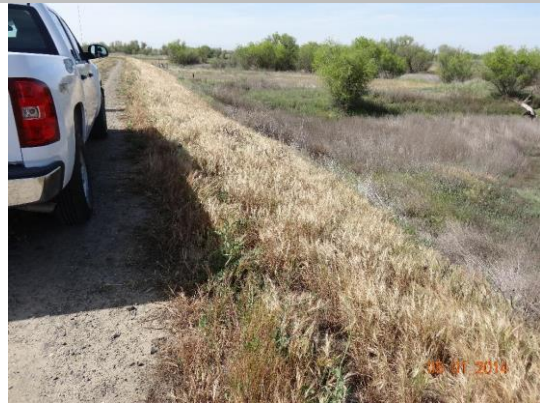
Photo 3 of 3 : UCIP_FA_2015_4974.jpg

View of waterward side.

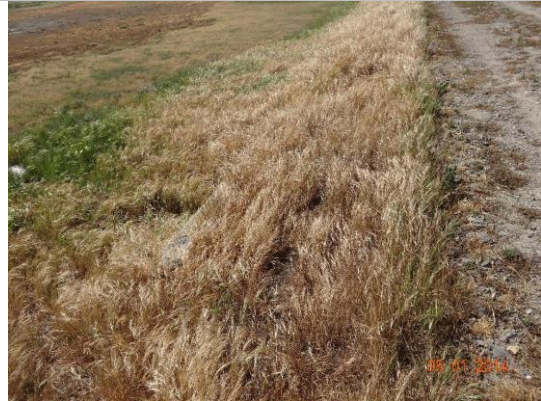
Photo 1 of 3 : UCIP_FA_2015_4975.jpg

LM Start	2.05	Rating **	M	Issue No.	14
LM End	2.05	Issue Type +	En	Location *	CR
Category	Supplemental			GPS Latitude/Longitude	
				Start	End
Item	DWR UCIP Field Study			37.277390 °	37.277390 °
				-120.867184 °	-120.867184 °
DWR ID					
Action/Comments					
Inspector Comments: FS_ID:36854					
DS_ID:19969					
EP_NO: N/A					
FS_HLM: 2.03					
Repair Type: Non-Urgent					
Crossing Status: Found

View of landward side.

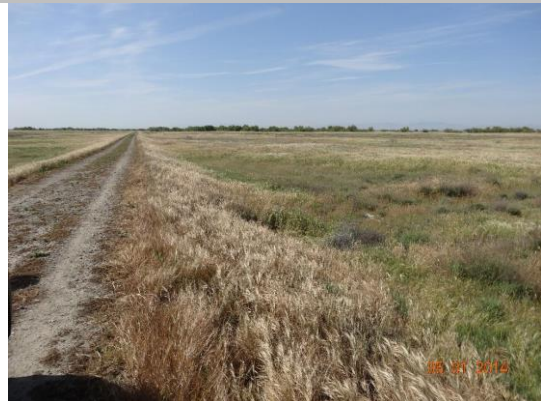
Photo 2 of 3 : UCIP_FA_2015_4976.jpg

View of waterward side.

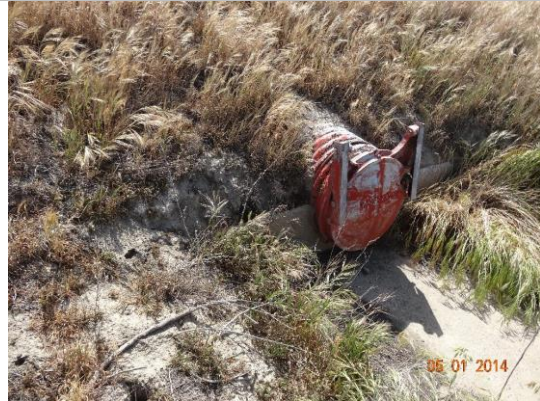
Photo 3 of 3 : UCIP_FA_2015_4977.jpg

LM Start	2.05	Rating **	M	Issue No.	14 (cont)
LM End	2.05	Issue Type +	En	Location *	CR
Category	Supplemental			GPS Latitude/Longitude	
				Start	End
Item	DWR UCIP Field Study			37.277390 °	37.277390 °
				-120.867184 °	-120.867184 °
DWR ID					
Action/Comments					
Inspector Comments: FS_ID:36854					
DS_ID:19969					
EP_NO: N/A					
FS_HLM: 2.03					
Repair Type: Non-Urgent					
Crossing Status: Found

Flap gate and concrete headwall located on waterward toe.

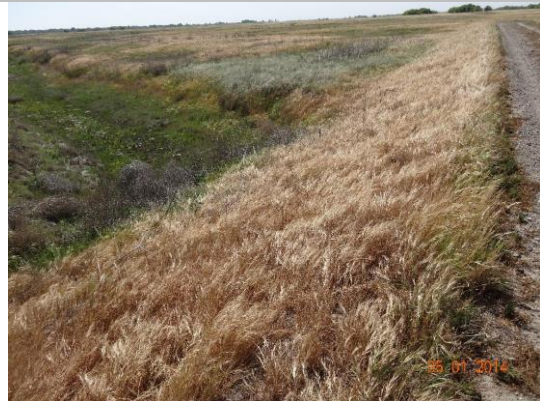
Photo 1 of 3 : UCIP_FA_2015_5116.jpg

LM Start	2.45	Rating **	M	Issue No.	15
LM End	2.45	Issue Type +	En	Location *	CR
Category	Supplemental			GPS Latitude/Longitude	
				Start	End
Item	DWR UCIP Field Study			37.271599 °	37.271599 °
				-120.866819 °	-120.866819 °
DWR ID					
Action/Comments					
Inspector Comments: FS_ID:39502 DS_ID:19970 EP_NO: N/A FS_HLM: 2.44 Repair Type: Non-Urgent Crossing Status: Found UCIP Comments: Dense vegetation limits the inspectors visibility to identify signs of pipe failure (leaks) along the slope. Recommend removing vegetation along pipe alignment to conduct proper inspection of structure. Sediment buildup in pipe visible on landward side-- recommend clearing. FIELD_STRUCT_DESC: 24-inch CM pipe through the levee, 11.2 feet below the crown. Flap gate on the waterward end. (USACE-1967). This entry matches the Drainage or Irrigation Structure referenced in O&M manual (HLM 2.45). FS Date: 05/01/2014

View of landward side.

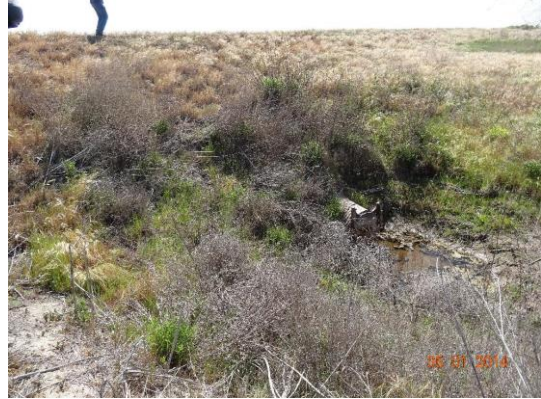
Photo 2 of 3 : UCIP_FA_2015_5117.jpg

LM Start	2.45	Rating **	M	Issue No.	15 (cont)
LM End	2.45	Issue Type +	En	Location *	CR
Category	Supplemental			GPS Latitude/Longitude	
				Start	End
Item	DWR UCIP Field Study			37.271599 °	37.271599 °
				-120.866819 °	-120.866819 °
DWR ID					
Action/Comments					
Inspector Comments: FS_ID:39502 DS_ID:19970 EP_NO: N/A FS_HLM: 2.44 Repair Type: Non-Urgent Crossing Status: Found UCIP Comments: Dense vegetation limits the inspectors visibility to identify signs of pipe failure (leaks) along the slope. Recommend removing vegetation along pipe alignment to conduct proper inspection of structure. Sediment buildup in pipe visible on landward side--recommend clearing. FIELD_STRUCT_DESC: 24-inch CM pipe through the levee, 11.2 feet below the crown. Flap gate on the waterward end. (USACE-1967). This entry matches the Drainage or Irrigation Structure referenced in O&M manual (HLM 2.45). FS Date: 05/01/2014

Pipe daylights at waterward toe.

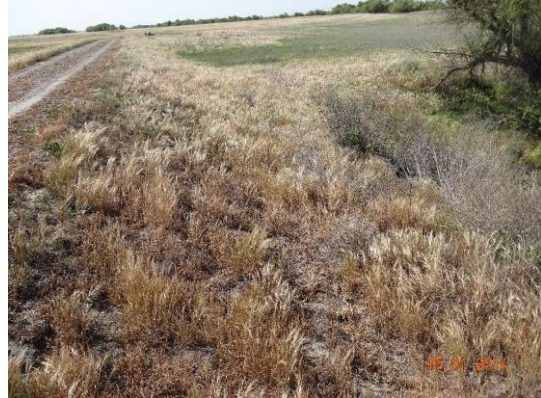
Photo 3 of 3 : UCIP_FA_2015_5118.jpg

View of waterward side.
