**Flood Control Project Maintenance  
Levee Inspections****LMA District Cover Sheet****Spring 2012 Levee Inspection Results****Lower San Joaquin Levee District**

Waterway			Bank	Unit Miles
Unit No. 01 San Joaquin River			Right	22.56
	Spring (March - May)	Summer (June - August)	(September - November) Fall	Winter (December - February)
Unit Maintenance Rating (Fall Only)				
Date of Inspection	4/23/2012 - 4/26/2012			
DWR Inspector	Richard Willoughby			
Accompanied By

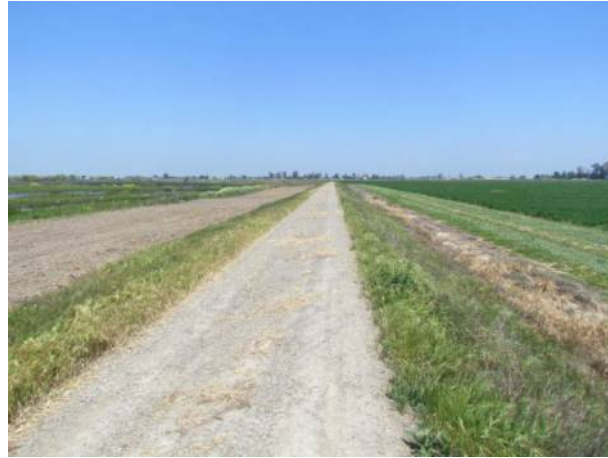
richard\_s\_20120430\_279.jpg

Looking south at typical view of levee.

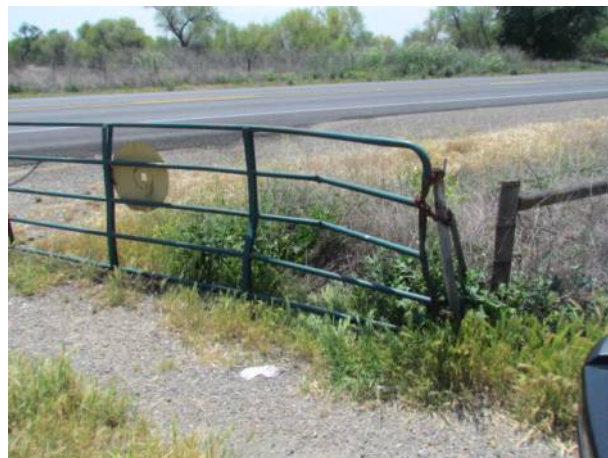
richard\_s\_20120430\_280.jpg

Looking southwest at damaged gate.

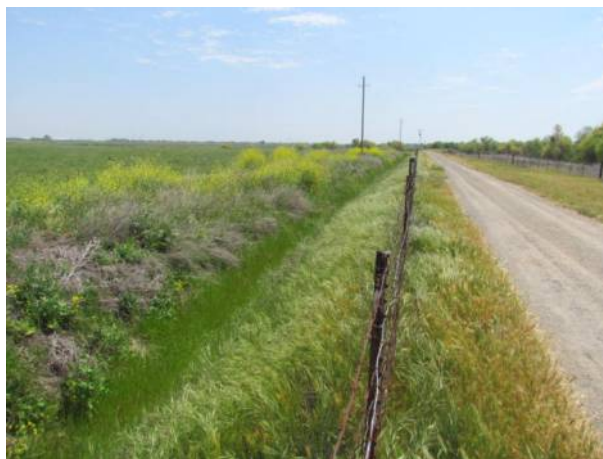
richard\_s\_20120430\_282.jpg

Looking south at irrigation ditch at landside toe.

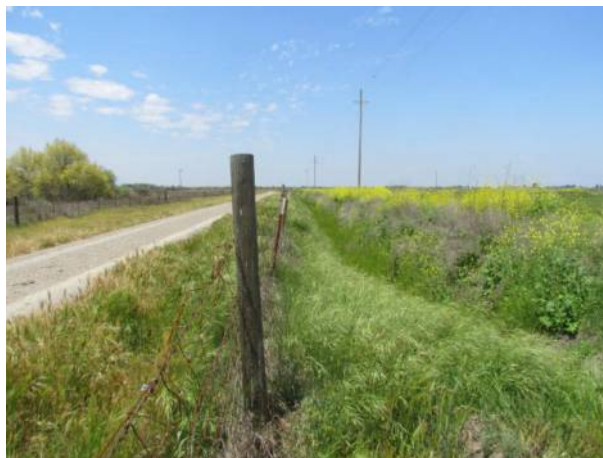
richard\_s\_20120430\_283.jpg

Looking north at irrigation ditch at landside toe.

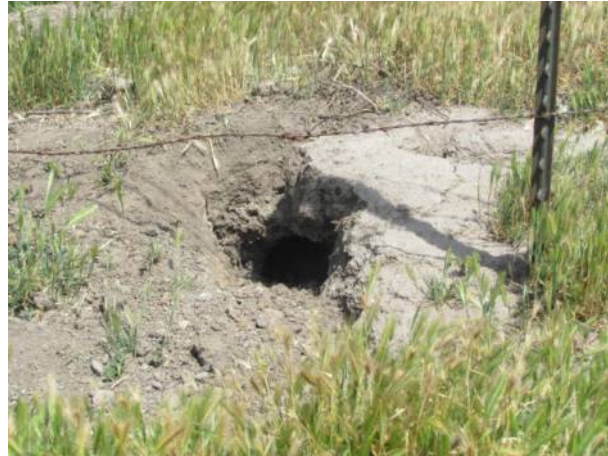
richard\_s\_20120430\_284.jpg

Looking east at one of several rodent holes on landside shoulder and slope.

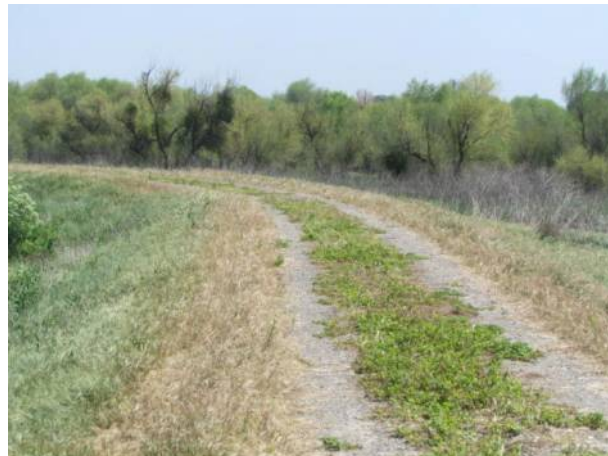
richard\_s\_20120430\_286.jpg

Looking south at typical view of vegetation on levee crown.

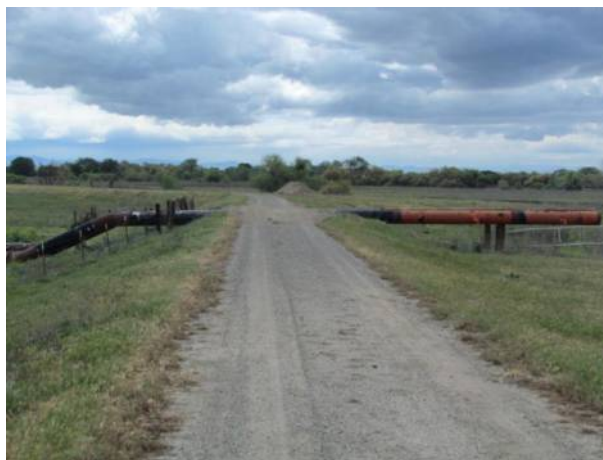
richard\_s\_20120507\_360.jpg

Looking south at pipe across levee crown.

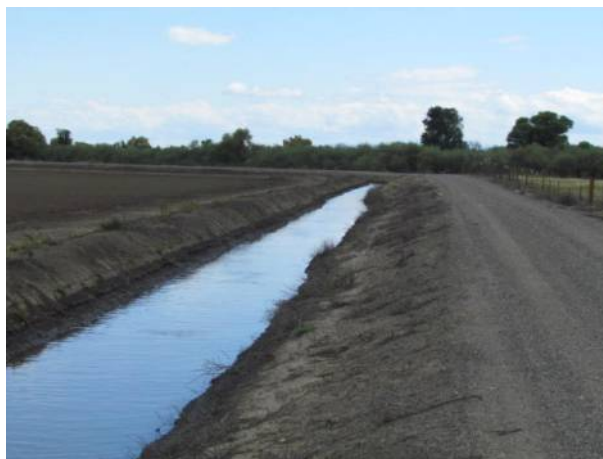
richard\_s\_20120507\_361.jpg

Looking upstream at irrigation at landside toe.

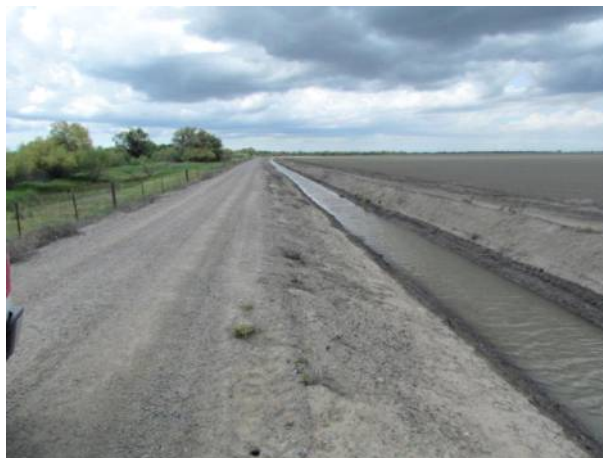
richard\_s\_20120507\_362.jpg

Looking downstream at irrigation ditch at landside toe.

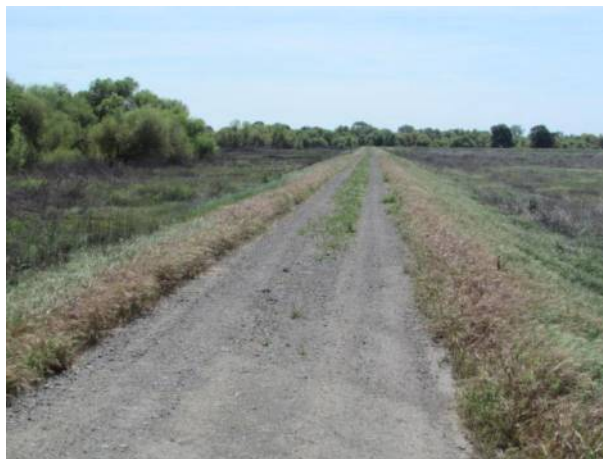
richard\_s\_20120507\_369.jpg

Looking south at typical view of levee.

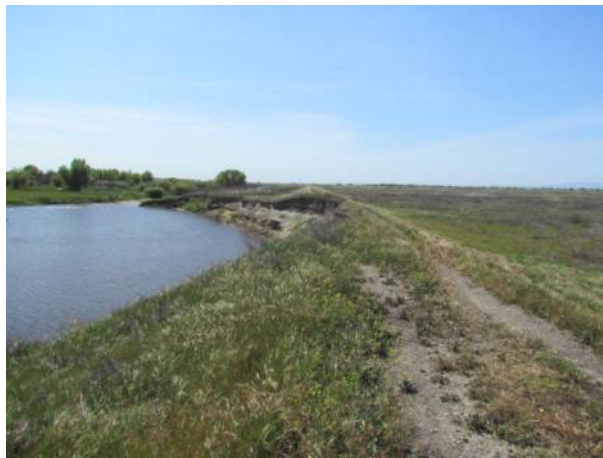
richard\_s\_20120507\_372.jpg

Looking south at large erosion on waterside slope. (Spring 2012)

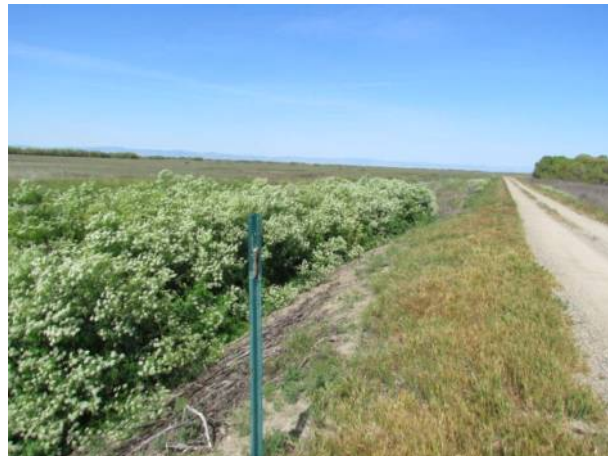
richard\_s\_20120507\_366.jpg

Looking north dense vegetation at landside slope and toe.

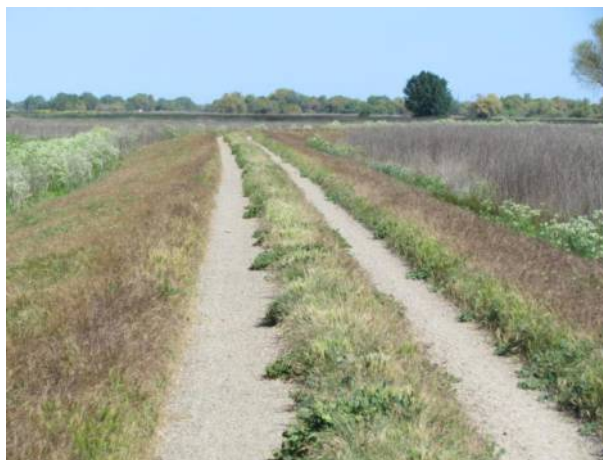
richard\_s\_20120507\_363.jpg

Looking north at vegetation on levee crown.

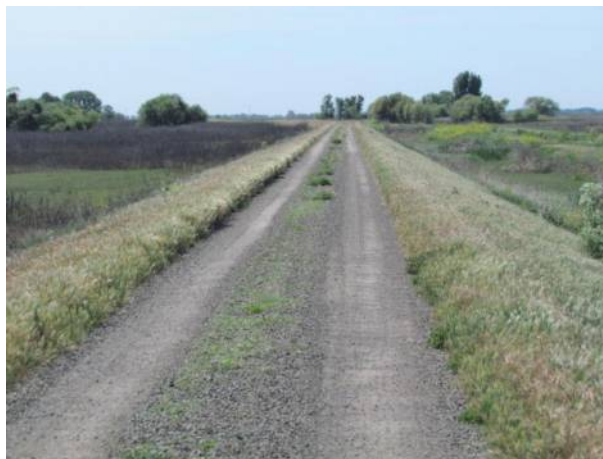
richard\_s\_20120507\_365.jpg

Looking south at typical view of levee.

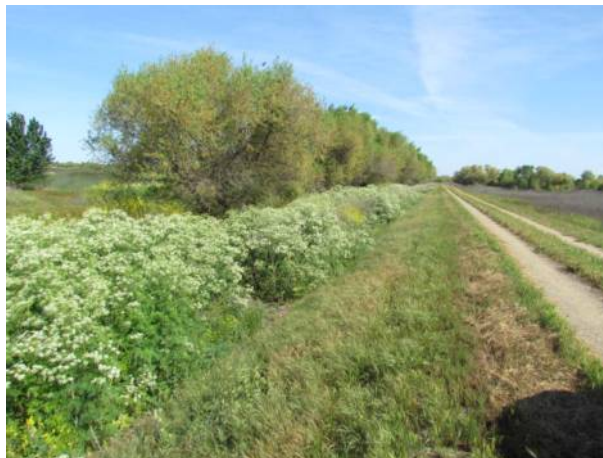
richard\_s\_20120507\_364.jpg

Looking northwest at dense vegetation on landside slope and toe.

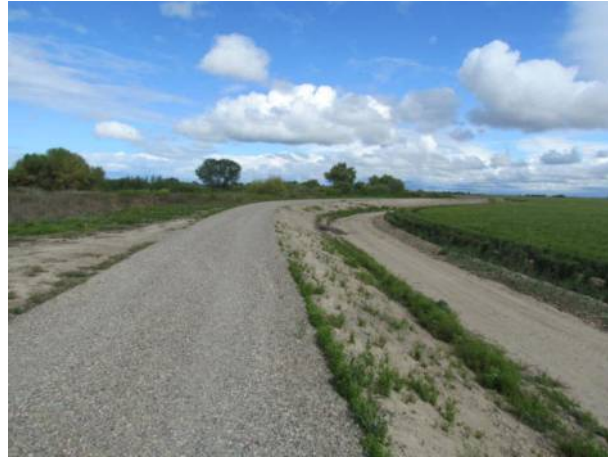
richard\_s\_20120507\_350.jpg

Looking downstream at typical view of levee.

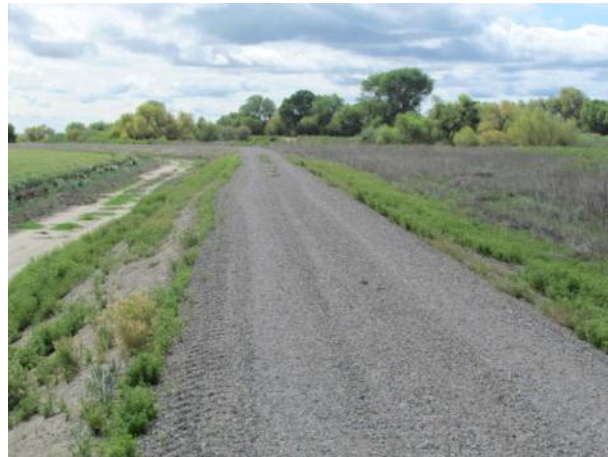
richard\_s\_20120507\_349.jpg

Looking upstream at typical view of levee.

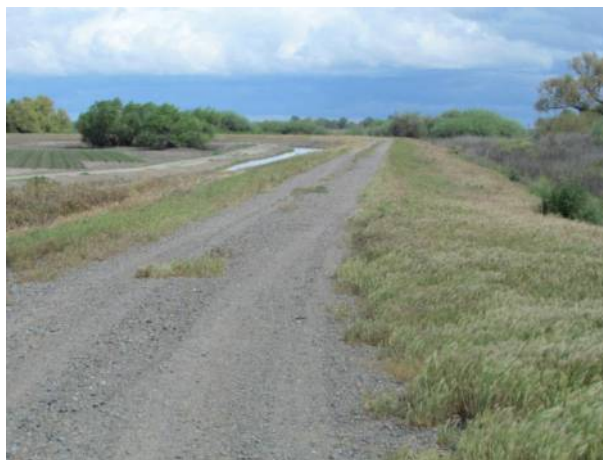
richard\_s\_20120507\_355.jpg

Looking south at typical view of levee.

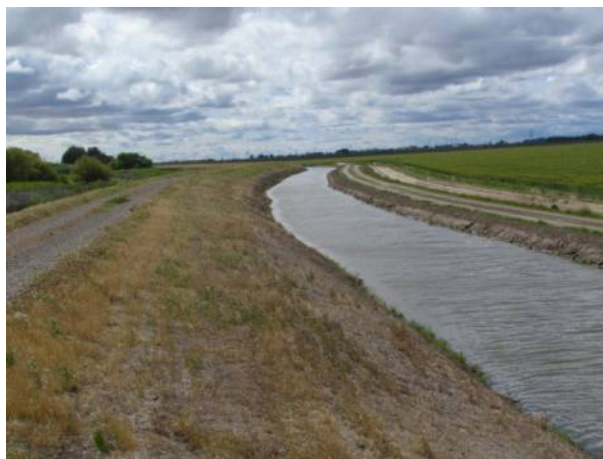
richard\_s\_20120507\_353.jpg

Looking north at irrigation ditch at landside toe.

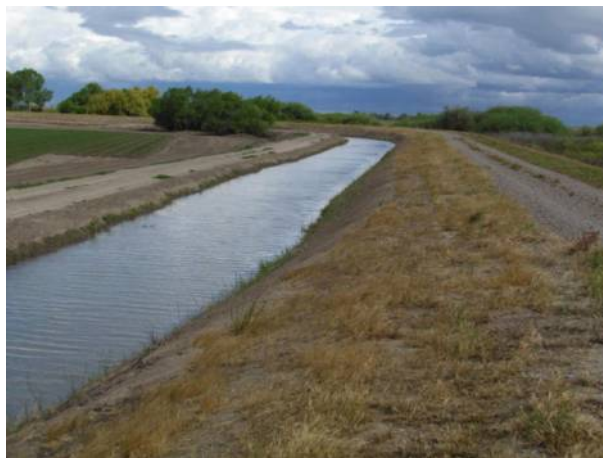
richard\_s\_20120507\_354.jpg

Looking north at irrigation ditch at landside toe.

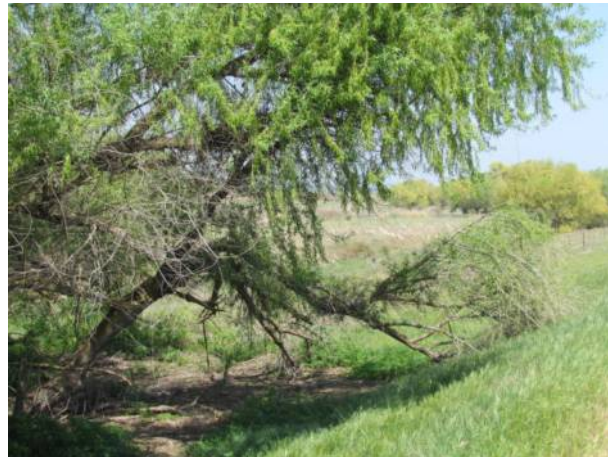
richard\_s\_20120430\_287.jpg

Looking south at down tree limb on landside slope and toe.

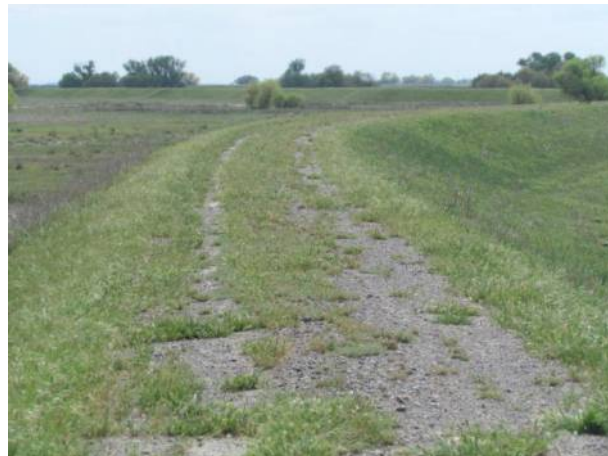
richard\_s\_20120430\_305.jpg

Looking south at vegetation on levee crown.

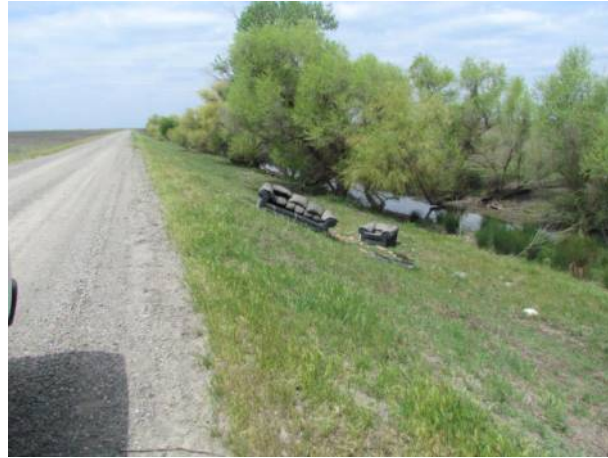
richard\_s\_20120501\_313.jpg

Looking east at garbage on landside slope.(Spring 2012)

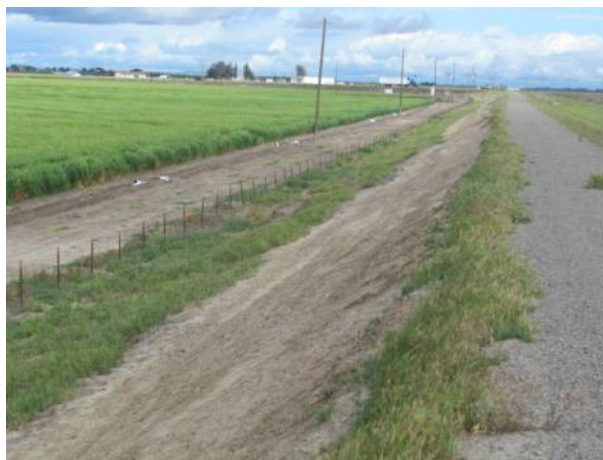
richard\_s\_20120507\_348.jpg

Looking north at livestock erosion on landside slope.

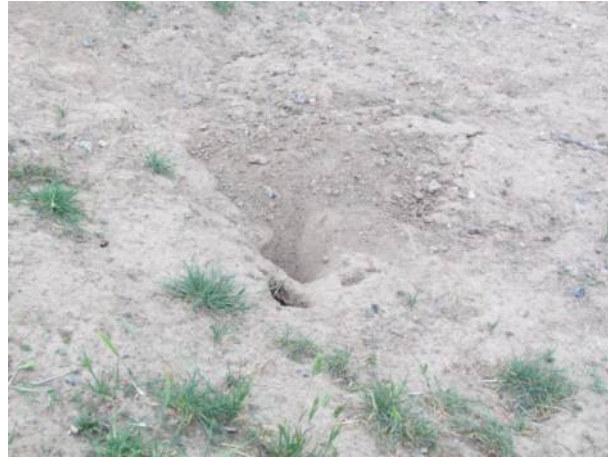
richard\_s\_20120507\_344.jpg

Looking at typical rodent hole on landside slope.

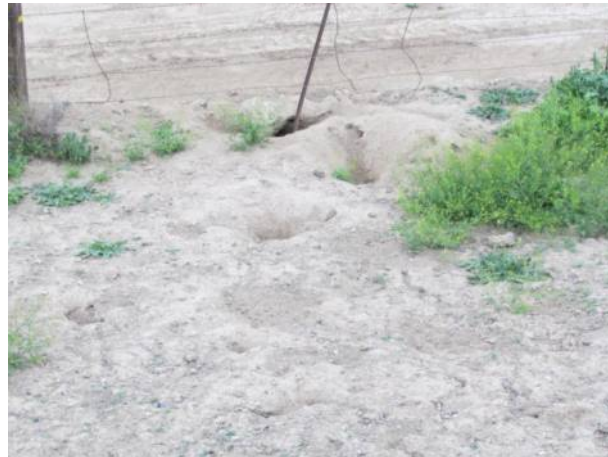
richard\_s\_20120507\_345.jpg

Looking west at rodent holes on landside slope and toe near fence line.

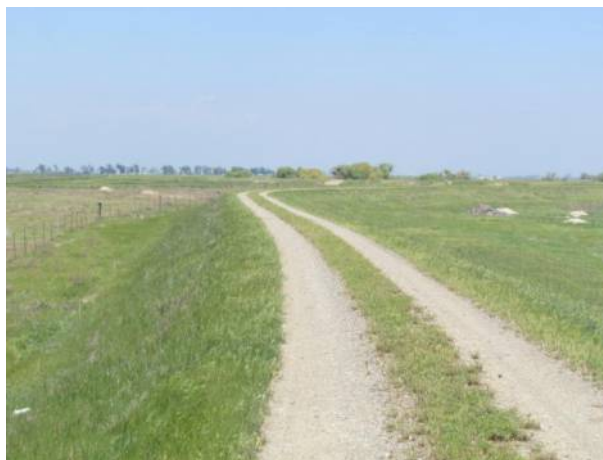
richard\_s\_20120430\_289.jpg

Looking west at typical view of levee.

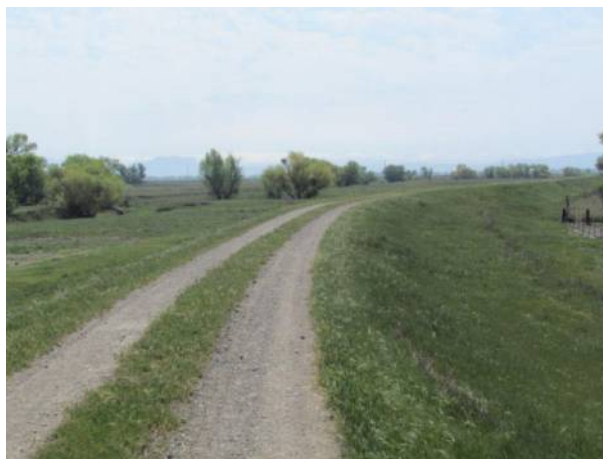
richard\_s\_20120430\_288.jpg

Looking east at typical view of levee.

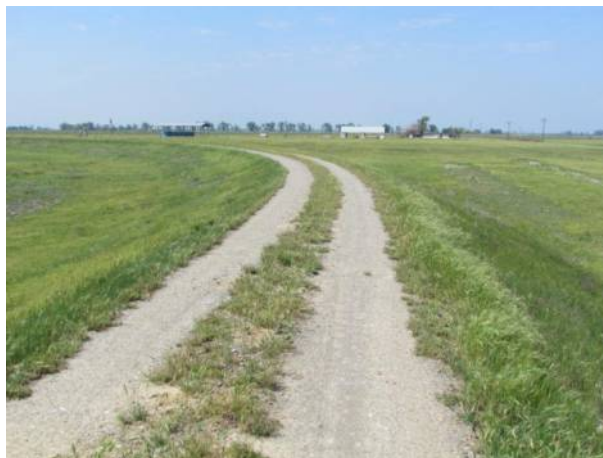
richard\_s\_20120430\_293.jpg

Looking east at vegetation on levee crown.

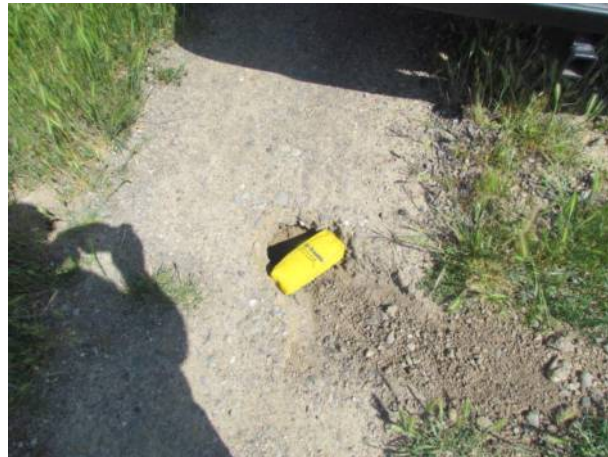
richard\_s\_20120430\_291.jpg

Looking at rodent hole on levee crown.

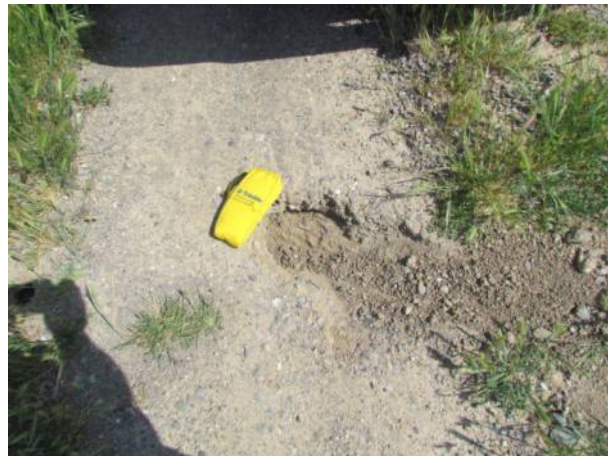
richard\_s\_20120430\_292.jpg

Looking at rodent hole on levee crown.

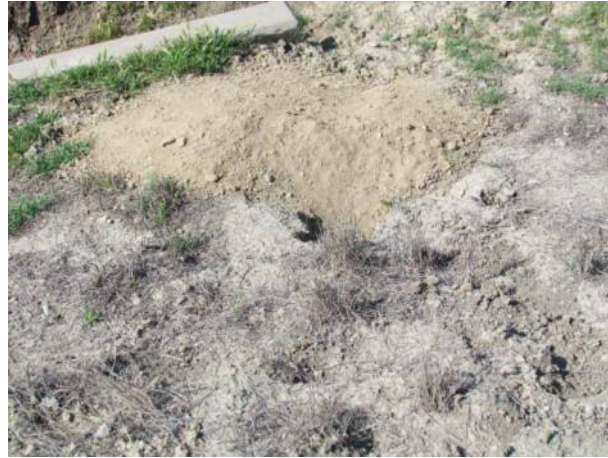
richard\_s\_20120430\_302.jpg

Looking at typical rodent hole on landside slope near headwall.

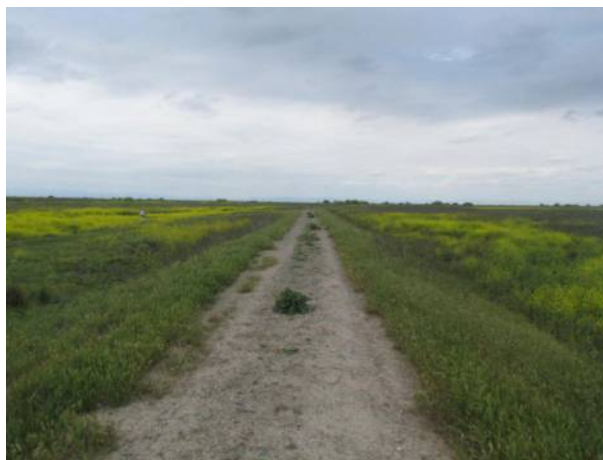
richard\_s\_20120430\_309.jpg

Looking west at a typical view of levee.

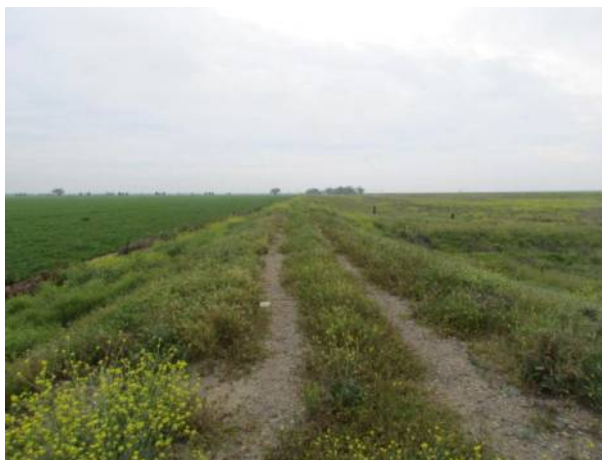
richard\_s\_20120501\_321.jpg

Looking east at unwanted vegetation on levee crown and slope.

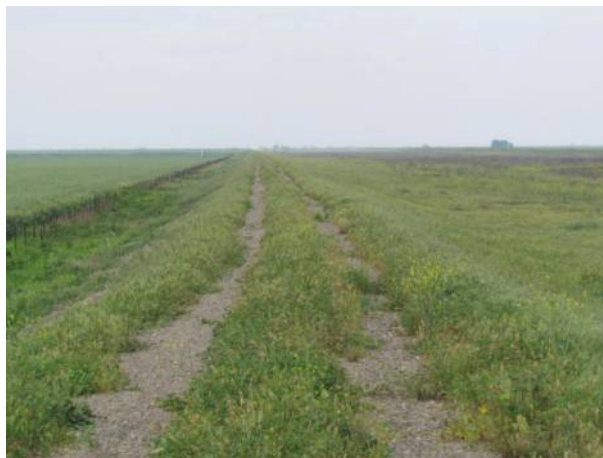
richard\_s\_20120501\_325.jpg

Levee Mile Report Line	3
Start Levee Mile	0.00
End Levee Mile	1.42
Location	Crown
Category	Earthen Levee
Item	Crown Surface / Depressions / Rutting

Looking west (downstream) at unwanted vegetation on levee crown.

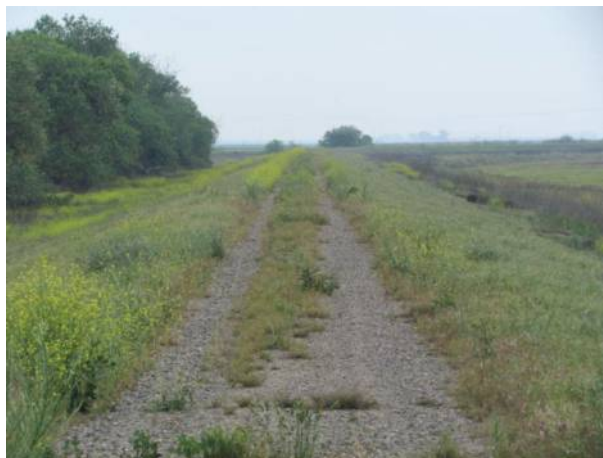
richard\_s\_20120501\_328.jpg

Levee Mile Report Line	3
Start Levee Mile	0.00
End Levee Mile	5.77
Location	Crown
Category	Earthen Levee
Item	Crown Surface / Depressions / Rutting

Looking south at unwanted vegetation on levee crown.

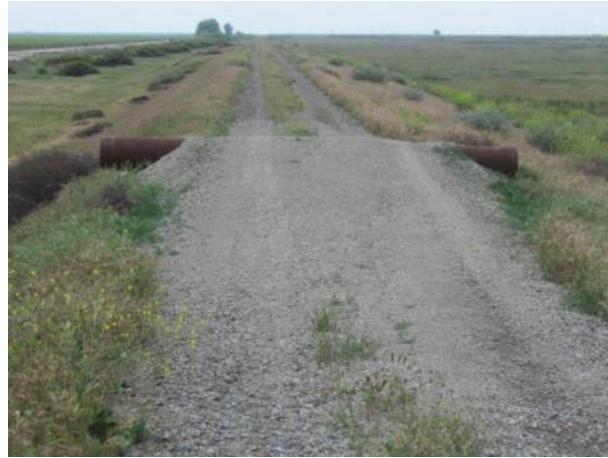
richard\_s\_20120501\_329.jpg

Looking south at unauthorized steel pipe across levee crown.

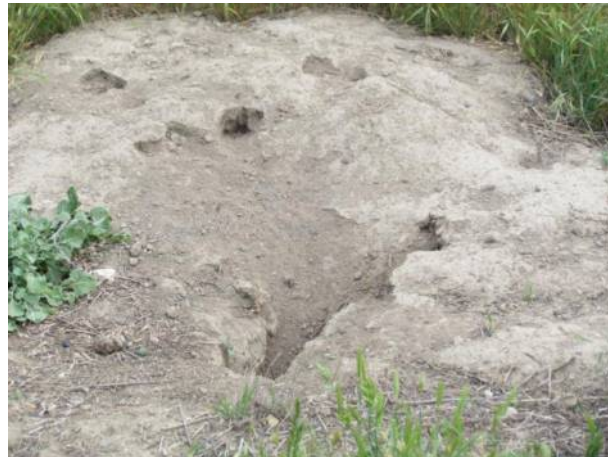
richard\_s\_20120501\_330.jpg

Levee Mile Report Line	5
Start Levee Mile	5.67
End Levee Mile	5.90
Location	Land Side
Category	Earthen Levee
Item	Animal Control

Looking at several rodent holes on landside slope.

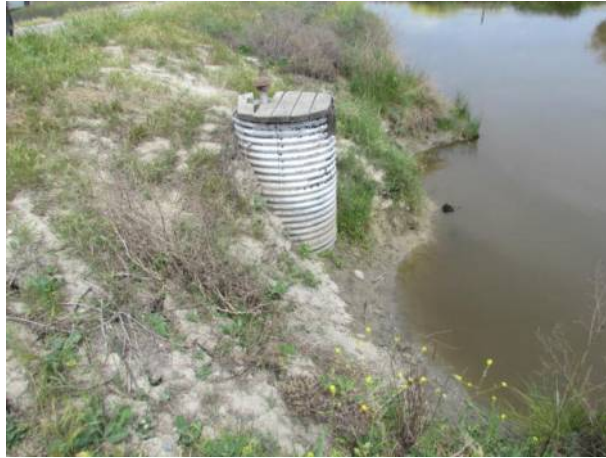
richard\_s\_20120430\_310.jpg

Looking north at erosion on waterside toe near screw gate.

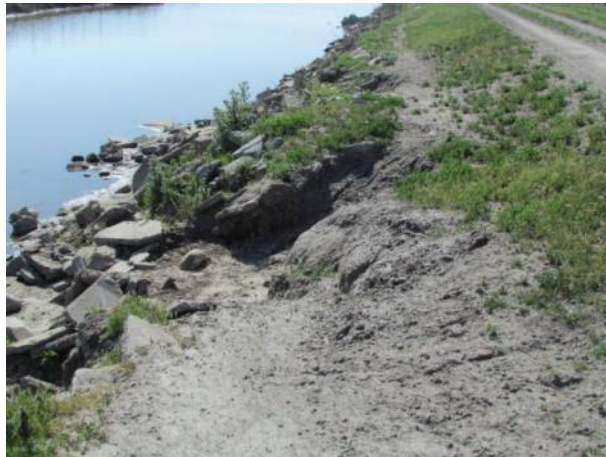
richard\_s\_20120430\_299.jpg

Levee Mile Report Line	5
Start Levee Mile	2.65
End Levee Mile	3.65
Location	Water Side
Category	Earthen Levee
Item	Animal Control

Looking northeast at animal erosion on waterside slope.

DWR ID: DWR_NA0010_22A_s_2012_8									
5	2.65	3.65	Earthen Levee	Animal Control	WS Ma	A2 : Repair the levee slope damaged by livestock and prevent large animal access. Inspector Comments: There're several slope stability issues along this channel cause by animal foot traffic that need to be monitored.	37.242563 ° -120.706435 °	37.253465 ° -120.717952 °	1 Y
DWR ID: DWR_NA0010_22A_s_2012_1									
6	3.14	3.14	Earthen Levee	Trim / Thin Trees	WS Ma	T2 : Thin trees to allow visibility of the ground and room to flood fight.	37.248208 ° -120.711500 °	37.248208 ° -120.711500 °	2
DWR ID: DWR_NA0010_22A_s_2012_2									
7	3.85	3.85	Channels	Encroachments	WS En	Inspector Comments: Stevenson Irrigation District constructed a concrete weir across channel without a permit. Still waiting for permit.	37.255568 ° -120.720551 °	37.255568 ° -120.720551 °	4 Y
DWR ID: DWR_NA0010_22A_s_2012_4									
8	4.25	4.32	Earthen Levee	Crown Surface / Depressions / Rutting	CR Ma	C2 : Regrade the crown roadway for proper drainage.	37.259822 ° -120.725557 °	37.259823 ° -120.725558 °	52

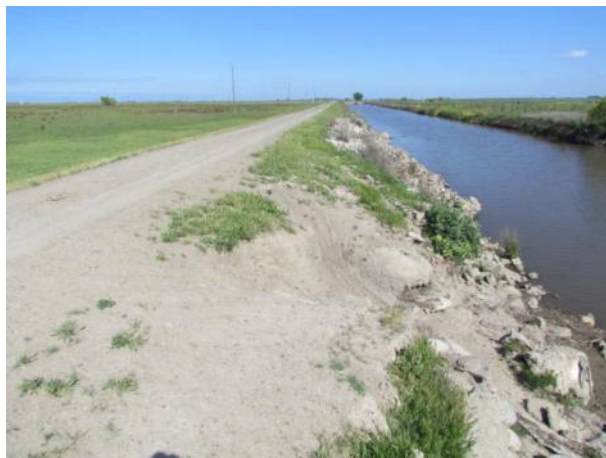
richard\_s\_20120430\_300.jpg

Levee Mile Report Line	5
Start Levee Mile	2.65
End Levee Mile	3.65
Location	Water Side
Category	Earthen Levee
Item	Animal Control

Looking south at animal erosion on waterside slope.

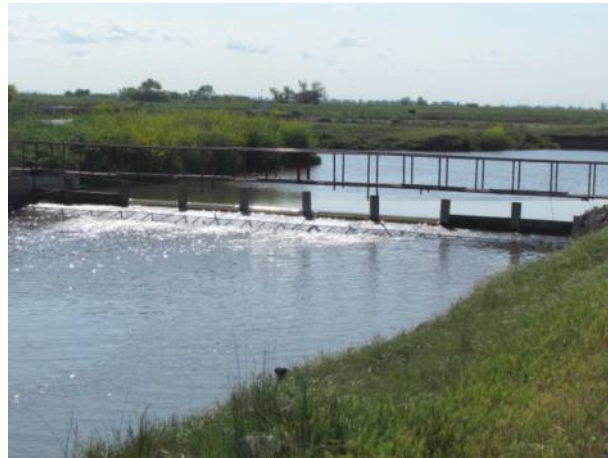
richard\_s\_20120430\_298.jpg

Looking north at unauthorized weir across Eastside Canal.

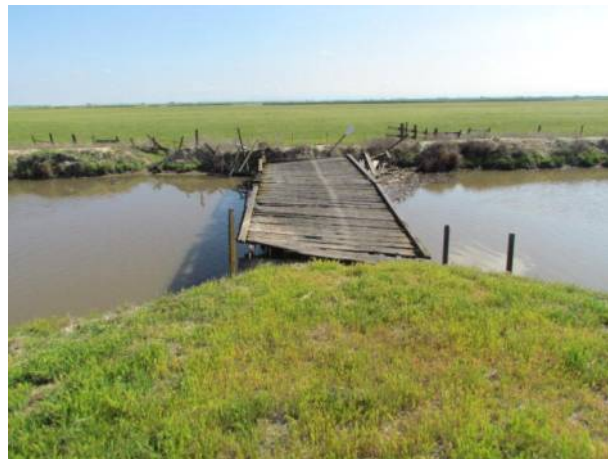
richard\_s\_20120430\_296.jpg

Levee Mile Report Line	9
Start Levee Mile	4.68
End Levee Mile	4.68
Location	Water Side
Category	Channels
Item	Encroachments

Looking east at dilapidated bridge across canal.

DWR ID: DWR_NA0010_22A_s_2012_52									
9	4.68	4.68	Channels	Encroachments	WS En	Inspector Comments: Old wooden bridge in channel should be removed.	37.264250 ° -120.731280 °	37.264250 ° -120.731280 °	3 Y
DWR ID: DWR_NA0010_22A_s_2012_3									
10	4.80	4.86	Earthen Levee	Animal Control	WS Ma	A2 : Repair the levee slope damaged by livestock and prevent large animal access. Inspector Comments: Erosion caused by livestock on waterside toe.	37.265180 ° -120.732745 °	37.265743 ° -120.733602 °	5 Y
DWR ID: DWR_NA0010_22A_s_2012_5									
11	4.81	4.84	Earthen Levee	Crown Surface / Depressions / Rutting	CR Ma	C3 : Add appropriate gravel or road base. Grade and compact.	37.265330 ° -120.732960 °	37.265705 ° -120.733553 °	10
DWR ID: DWR_NA0010_22A_s_2012_10									
12	5.07	5.10	Earthen Levee	Crown Surface / Depressions / Rutting	CR Ma	C2 : Regrade the crown roadway for proper drainage. Inspector Comments: Minor rutting on levee crown.	37.267682 ° -120.736597 °	37.267967 ° -120.736913 °	9 Y

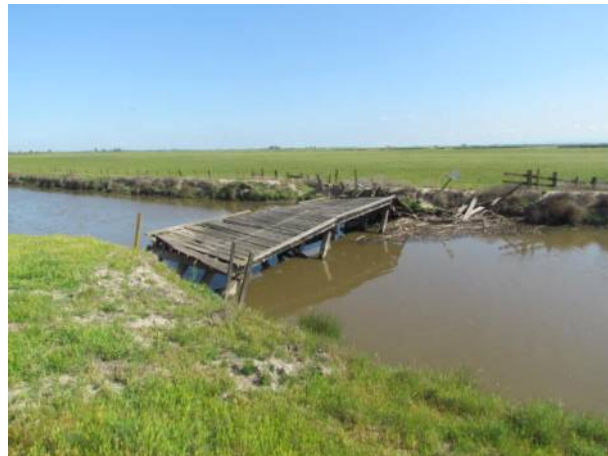
richard\_s\_20120430\_297.jpg

Levee Mile Report Line	9
Start Levee Mile	4.68
End Levee Mile	4.68
Location	Water Side
Category	Channels
Item	Encroachments

Looking northeas at dilapidated bridge across canal.

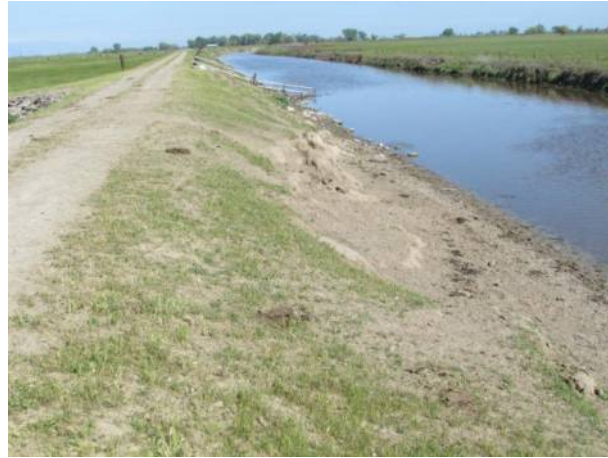
richard\_s\_20120430\_295.jpg

Looking north at waterside erosion from livestock.

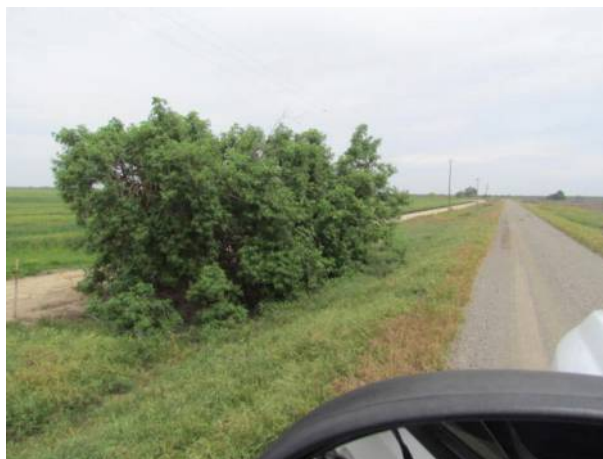
richard\_s\_20120501\_333.jpg

Levee Mile Report Line	5
Start Levee Mile	2.85
End Levee Mile	2.85
Location	Land Side
Category	Earthen Levee
Item	Vegetation

Looking south at elderberry on landside toe and berm.

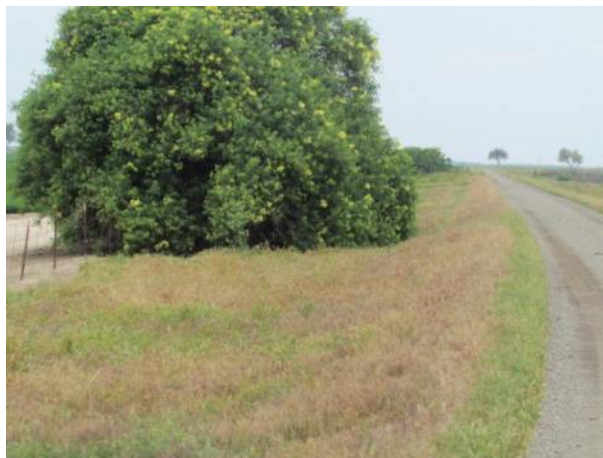
richard\_s\_20120501\_334.jpg

Levee Mile Report Line	6
Start Levee Mile	3.30
End Levee Mile	3.30
Location	Land Side
Category	Earthen Levee
Item	Vegetation

Looking south at elderberry on landside toe and berm.

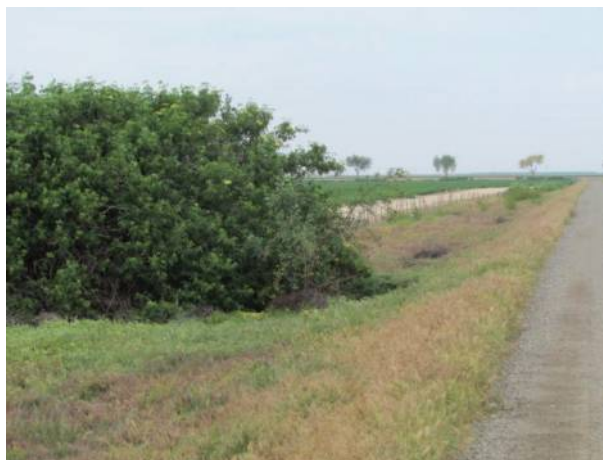
richard\_s\_20120501\_335.jpg

Looking south at elderberry on landside toe and berm.

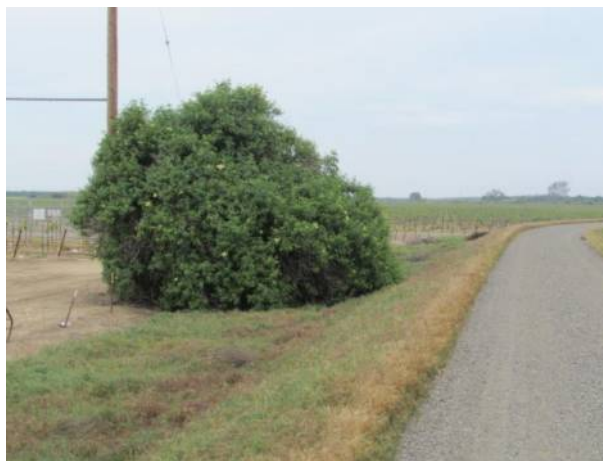
richard\_s\_20120501\_336.jpg

Levee Mile Report Line	8
Start Levee Mile	4.14
End Levee Mile	4.14
Location	Land Side
Category	Earthen Levee
Item	Vegetation

Looking south at elderberry on landside toe and berm.

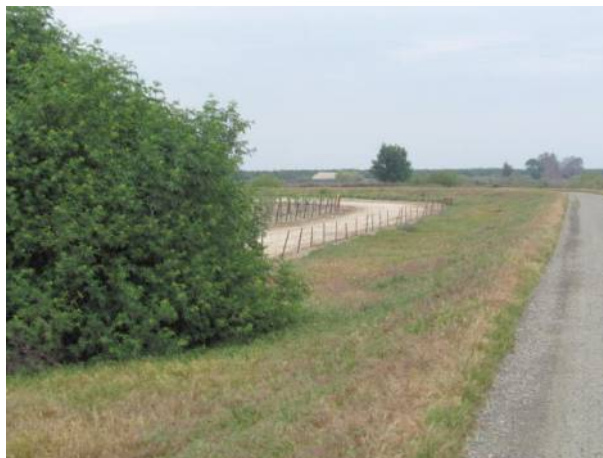
richard\_s\_20120501\_337.jpg

Levee Mile Report Line	9
Start Levee Mile	4.46
End Levee Mile	4.46
Location	Land Side
Category	Earthen Levee
Item	Vegetation

Looking south at elderberry on landside toe and berm.

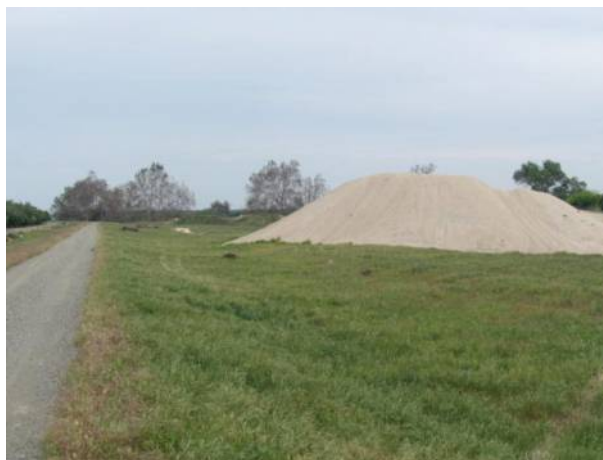
richard\_s\_20120501\_338.jpg

Looking south at sand pile 20-30 feet away from waterside slope.

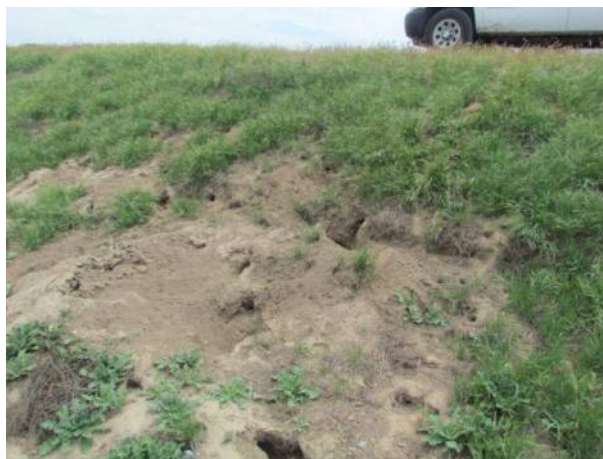
richard\_s\_20120501\_339.jpg

Levee Mile Report Line	11
Start Levee Mile	5.69
End Levee Mile	5.90
Location	Water Side
Category	Earthen Levee
Item	Animal Control

Looking at several rodent holes on landside slope.

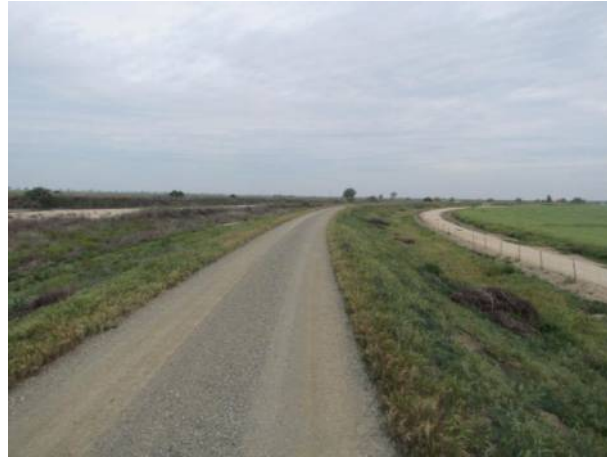
richard\_s\_20120501\_340.jpg

Looking north at typical view of levee.

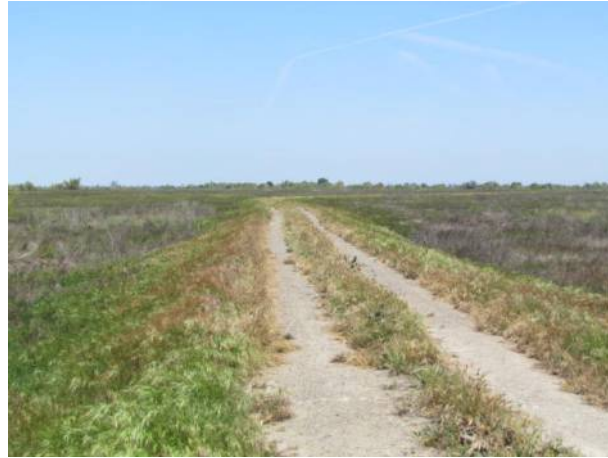
richard\_s\_20120507\_374.jpg

Looking northeast at a typical view of levee.

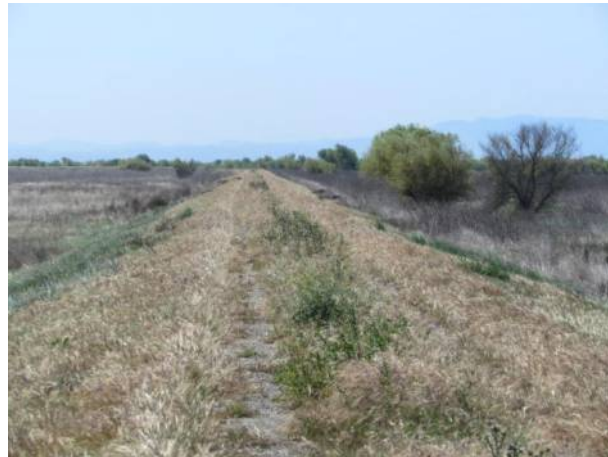
richard\_s\_20120507\_373.jpg

Levee Mile Report Line	2
Start Levee Mile	0.00
End Levee Mile	2.47
Location	Crown
Category	Earthen Levee
Item	Crown Surface / Depressions / Rutting

Looking west at vegetation on levee crown.
