Flood Control Project Maintenance Levee Inspections

Fall 2022 Levee Maintenance Deficiency Summary Report

San Joaquin River Basin

Merced Streams Group

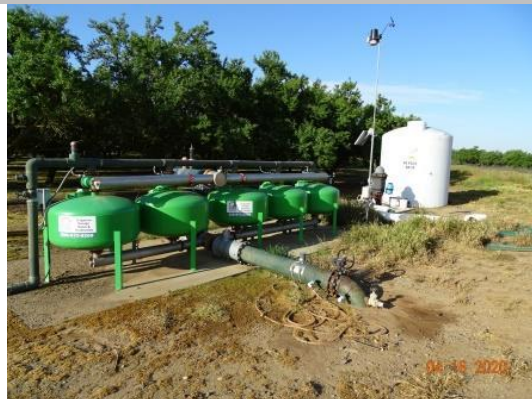
Photo 1 of 1 : FA_2022_NA0013_332_2_20220822_00001.jpg

LM Start	0.00	Rating **	U	Issue No.	2
LM End	0.00	Issue Type +	En	Location *	LS
Category	Earthen Levee			GPS Latitude/Longitude	
				Start	End
Item	Encroachments			37.337034 °	37.337034 °
				-120.387422 °	-120.387422 °
DWR ID	DWR_NA0013_02_f_2012_2				
Comment Code					
PI : Pipe					
Inspector Comment					
There is no CVFPB permit on record for this issue. Merced County Flood Control is aware of this issue.

Tank and filtration system installed on the landside easement. (Spring 2020)

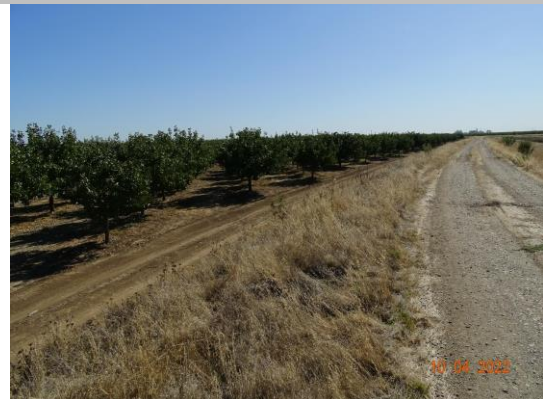
Photo 1 of 1 : FA_2022_NA0013_332_19_20221020_00016.jpg

LM Start	0.63	Rating **	U	Issue No.	19
LM End	0.83	Issue Type +	Ma	Location *	LS
Category	Earthen Levee			GPS Latitude/Longitude	
				Start	End
Item	Vegetation			37.331906 °	37.329343 °
				-120.394159 °	-120.396005 °
DWR ID	DWR_NA0013_02_f _ 2022_19				
Comment Code					
V1 : Control annual grass and weeds on the levee slopes and easements.					
Inspector Comment

Looking upstream along the landside slope. (Fall 2022)

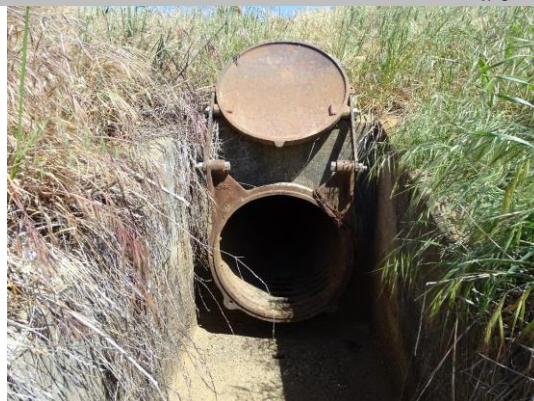
Photo 2 of 3 : UCIP_FA_2022_74587_111411.jpg

Comment Code						
Inspector Comment						
DS_ID:23057 FS_ID:74587 EP_NO: N/A Repair Type: Non-Urgent EVAL Issue: 5, Pipe Damage Crossing Status: Found UCIP Comments: 04/13/2022 Record updated from No Action Needed to Non-Urgent. DMP internal video inspection has found pipe integrity issues. LOF of crossing is greater than or equal to 4.1 and less than 5. Crossing will be monitored until funding becomes available for rehabilitation. Some damage has occurred to the LS concrete headwall since the last inspection. (M.Thao - DWR UCIP) 09/17/2013 - working during field inspection. (DWR UCIP - P. Amatya) FIELD_STRUCT_DESC: 24-inch corrugated metal gravity drainage pipe through the levee, 10 feet below the crown. Concrete headwall, flap gate, and concrete grouted cobble apron on the waterside (WS) toe. Concrete headwall on the landside (LS) toe. [Additional Reference(s): DWR Levee Log, 2005 (HLM 1.32). USACE San Joaquin O&M Manual 607, June 1962, (HLM 1.32), listed as 24-inch pipe]. FS Date: 4/13/2022

WS view: Concrete headwall, apron, and flap gate on toe.

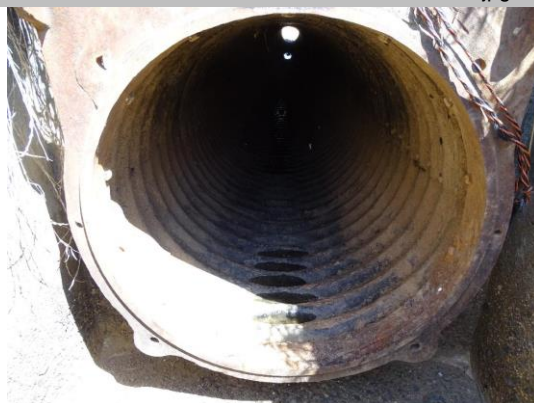
Photo 3 of 3 : UCIP_FA_2022_74587_111421.jpg

WS view: Inside view of pipe outlet; looks clean and clear.

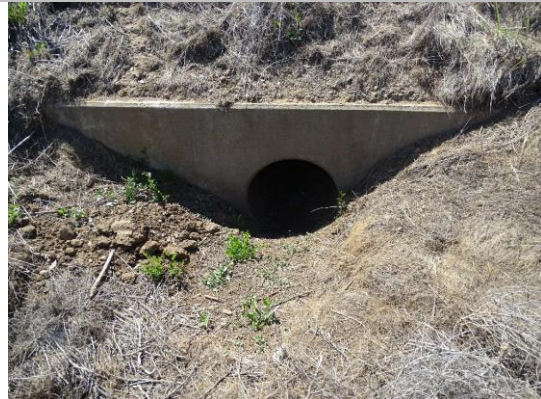
Photo 1 of 2 : UCIP_FA_2022_77425_111432.jpg

Comment Code						
Inspector Comment						
DS_ID:23058 FS_ID:77425 EP_NO: N/A Repair Type: Non-Urgent EVAL Issue: 5, Pipe Damage Crossing Status: Found UCIP Comments: 04/13/2022 Record remains Non-Urgent. DMP internal video inspection has found pipe integrity issues. LOF of crossing is greater than or equal to 4.1 and less than 5. Crossing will be monitored until funding becomes available for rehabilitation. Debris has deposited at the end of WS apron not allowing water to drainage properly; recommend removing debris. Pipe inlet on LS has been cleared since the last inspection. (M.Thao - DWR UCIP) 09/17/2013 - needs cleaning of debris on spillway on WS. Flapgate blocked by debris on WS. - needs cleaning inside CMP on LS. (DWR UCIP - P. Amatya) FIELD_STRUCT_DESC: 24-inch corrugated metal gravity drainage pipe through the levee, 8 feet below the crown. Concrete headwall, flap gate, and concrete grouted cobble apron on the waterside (WS) toe. Concrete headwall on the landside (LS) toe. [Additional Reference(s): DWR Levee Log, 2005 (HLM 1.64). USACE San Joaquin O&M Manual 607, June 1962, (HLM 1.64), listed as 24-inch pipe]. FS Date: 4/13/2022

LS view: Looking toward levee; concrete headwall and pipe inlet.

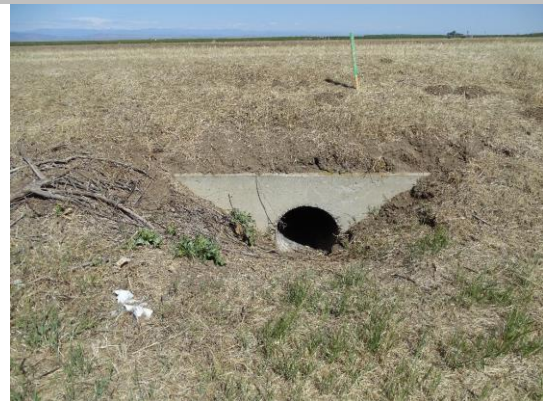
Photo 1 of 2 : UCIP_FA_2022_74597_111450.jpg

Comment Code						
Inspector Comment						
DS_ID:23060						
FS_ID:74597						
EP_NO: N/A						
Repair Type: Urgent						
EVAL Issue: 1, Pipe Integrity						
Crossing Status: Found						
UCIP Comments: 04/13/2022 Record remains Urgent. DMP internal video inspection has found pipe integrity issues. LOF of crossing is between 5 and 6. Crossing will be monitored until funding becomes available to address the issues. Pipe inlet on LS has been cleared since last inspection as well as vegetation on LS and WS. (M.Thao - DWR UCIP)						
09/17/2013 - more than a half of inet pipe burried on LS. - needs vegetation cleaning on both sides.- inlet needs silt removed and cleaning. (DWR UCIP - P. Amatya)						
FIELD_STRUCT_DESC: 24-inch corrugated metal gravity drainage pipe through the levee, 6 feet below the crown. Concrete headwall, flap gate, and concrete grouted cobble spillway on the waterside (WS) toe. Concrete headwall on the landside (LS) toe. [Additional Reference(s): DWR Levee Log, 2005 (HLM 0.20). USACE San Joaquin O&M Manual 607, June 1962, (HLM 0.18), listed as 24-inch pipe].

LS view: Concrete headwall and pipe inlet at toe.

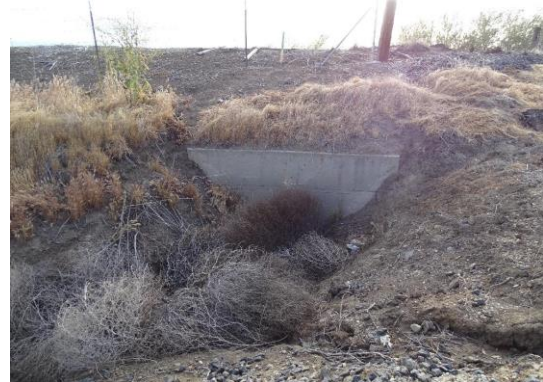
Photo 1 of 2 : UCIP_FA_2022_74601_111459.jpg

LS view: Concrete headwall; vegetation blocking pipe inlet.

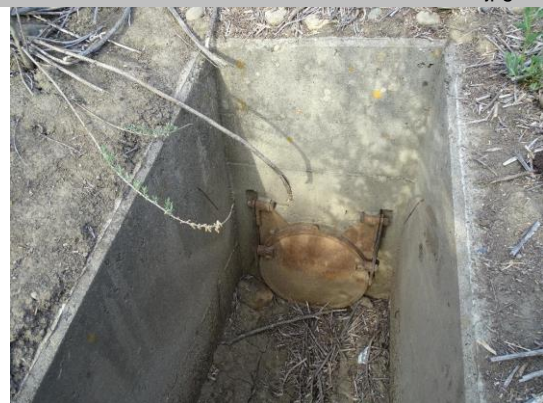
Photo 2 of 2 : UCIP_FA_2022_74601_111461.jpg

WS view: Close-up view of concrete headwall and flap gate.

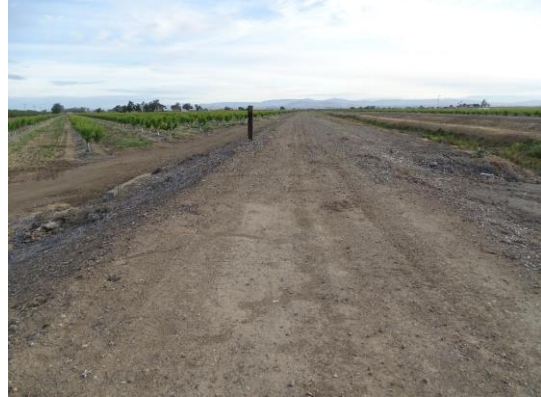
Photo 1 of 3 : UCIP_FA_2022_74603_111463.jpg

Comment Code					
Inspector Comment					
DS_ID:23062 FS_ID:74603 EP_NO: N/A Repair Type: No Action Needed EVAL Issue: Crossing Status: Found UCIP Comments: 04/14/2022 Record remains No Action Needed. DMP internal video inspection has not found pipe integrity issues. LOF of crossing is less or equal to 4. Recommend next video inspection in 5 years. No issues observed during inspection. (M.Thao - DWR UCIP) 09/29/2016: LS and WS ends have been cleared by Mike Walejko of NA0013. Crossing has been downgraded from Non-Urgent to No Action Needed. (K. Fazel - UCIP)09/2013:- needs clearing and cleaning on inlet and outlet. (P. Amatya - UCIP) FIELD_STRUCT_DESC: 24-inch corrugated metal gravity drainage pipe through the levee, 7.5 feet below the crown. Concrete headwall, flap gate, and concrete grouted cobble spillway on the waterside (WS) toe. Concrete headwall on the landside (LS) toe. [Additional Reference(s): DWR Levee Log, 2005 (HLM 0.59). USACE San Joaquin O&M Manual 607, June 1962, (HLM 0.59), listed as 24-inch pipe]. FS Date: 4/14/2022

Levee crown looking upstream.

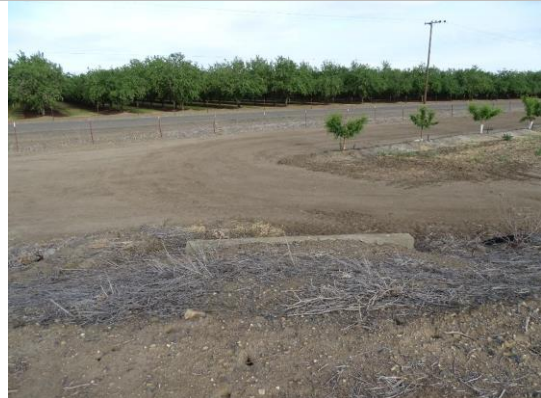
Photo 2 of 3 : UCIP_FA_2022_74603_111464.jpg

LS view: Looking from crown; backside of concrete headwall on toe.

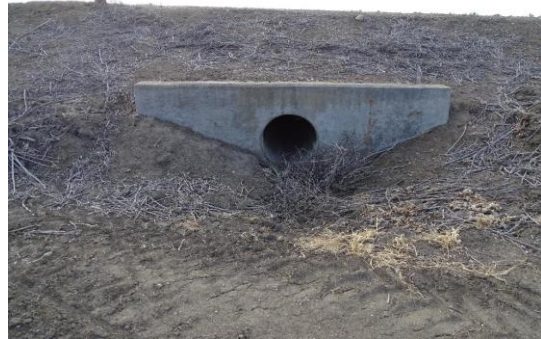
Photo 3 of 3 : UCIP_FA_2022_74603_111465.jpg

LS view: Concrete headwall and pipe inlet on toe.

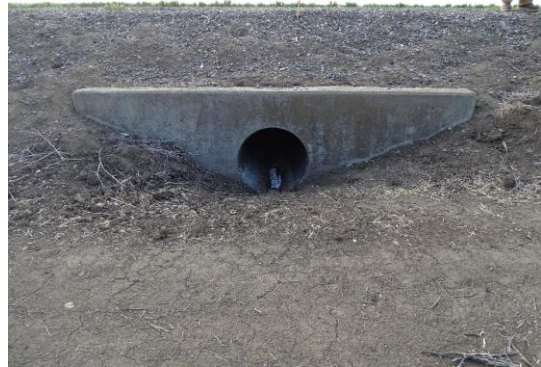
Photo 1 of 2 : UCIP_FA_2022_74604_111470.jpg

LS view: Concrete headwall and pipe inlet on toe.

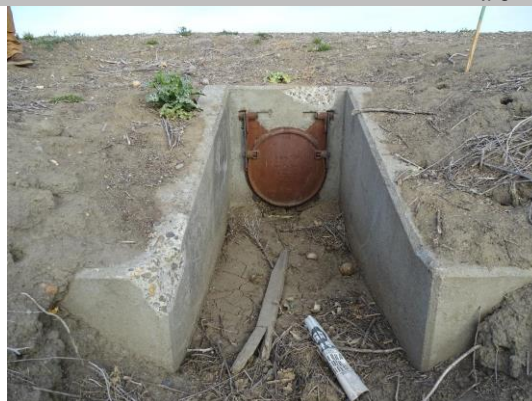
Photo 2 of 2 : UCIP_FA_2022_74604_111467.jpg

WS view: Concrete headwall, spillway, and flap gate on toe.

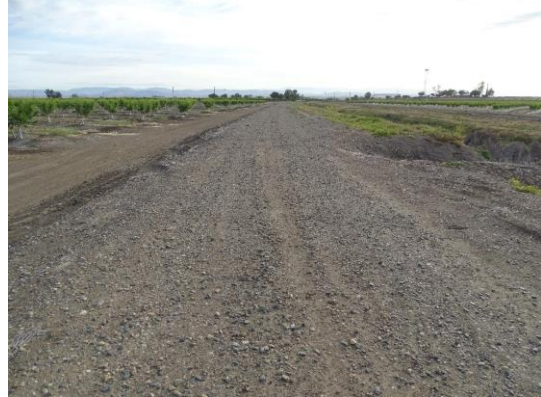
Photo 1 of 3 : UCIP_FA_2022_74606_111473.jpg

Levee crown looking upstream.

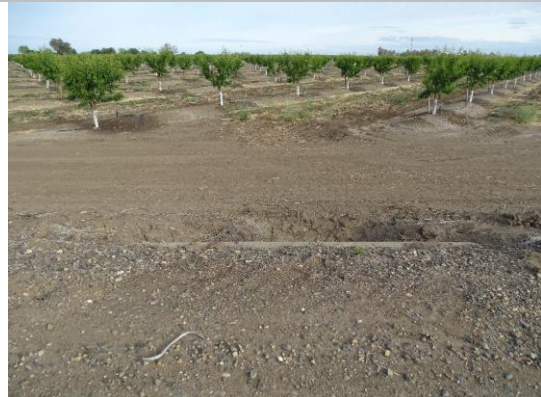
Photo 2 of 3 : UCIP_FA_2022_74606_111474.jpg

LS view: Looking from crown; general overview.

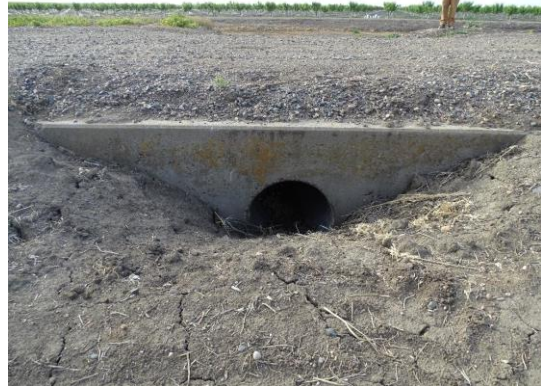
Photo 3 of 3 : UCIP_FA_2022_74606_111475.jpg

LS view: Concrete headwall and pipe inlet on toe.

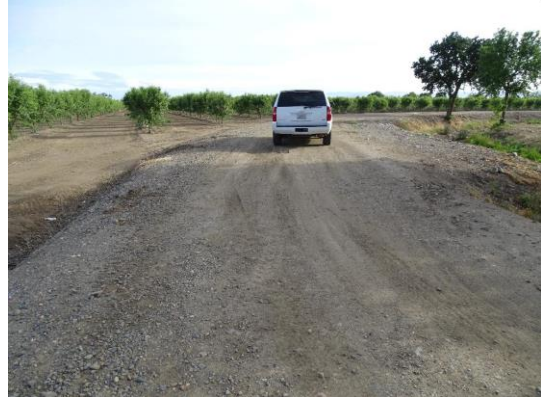
Photo 1 of 3 : UCIP_FA_2022_74610_111482.jpg

Levee crown looking upstream.

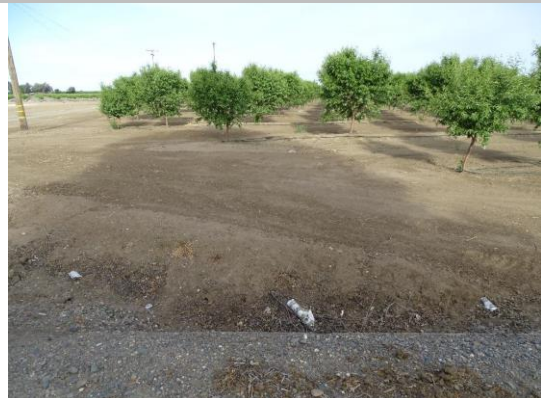
Photo 2 of 3 : UCIP_FA_2022_74610_111483.jpg

LS view: Looking from crown; general overview.

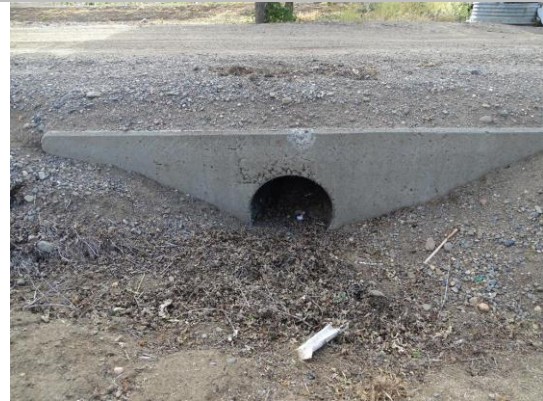
Photo 3 of 3 : UCIP_FA_2022_74610_111484.jpg

LS view: Concrete headwall and pipe inlet on toe.

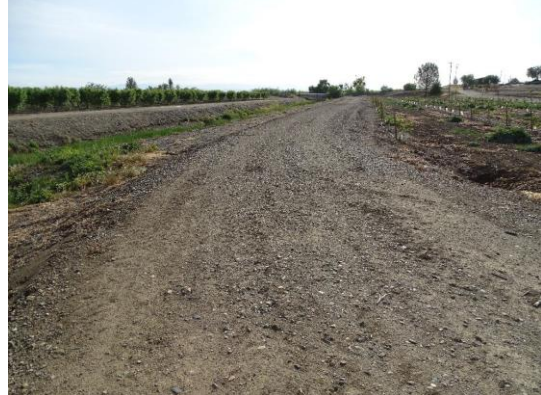
Photo 1 of 3 : UCIP_FA_2022_77414_111520.jpg

Levee crown looking downstream.

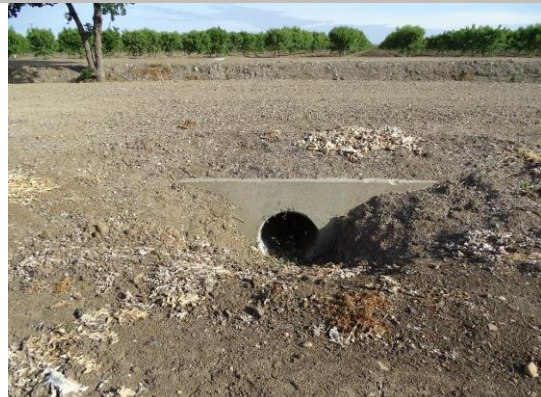
Photo 2 of 3 : UCIP_FA_2022_77414_111521.jpg

LS view: Concrete headwall and pipe inlet on toe.

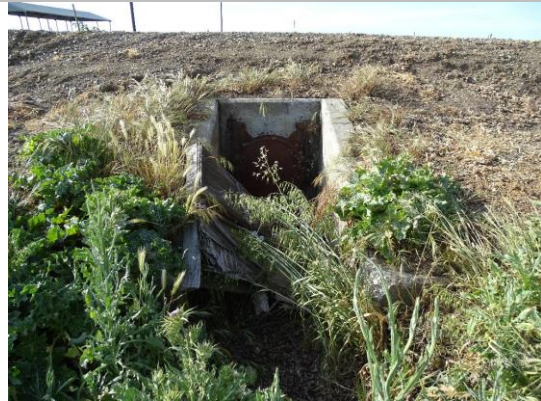
Photo 3 of 3 : UCIP_FA_2022_77414_111522.jpg

WS view: Concrete headwall, spillway, and flap gate on toe.

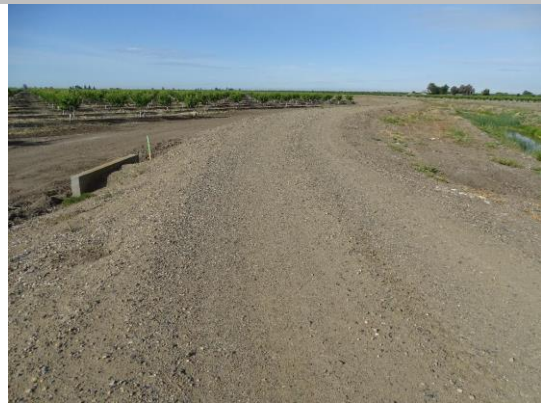
Photo 1 of 3 : UCIP_FA_2022_74658_111523.jpg

Levee crown looking downstream.

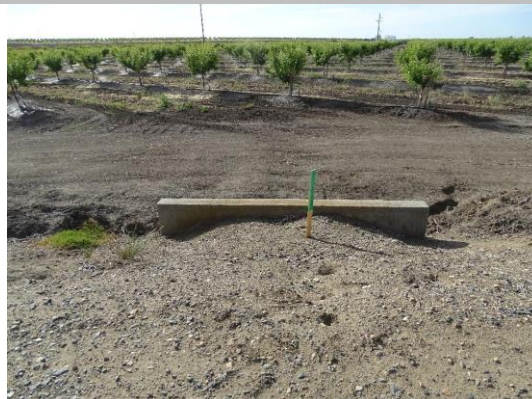
Photo 2 of 3 : UCIP_FA_2022_74658_111524.jpg

LS view: Looking from crown; backside of concrete headwall on toe.

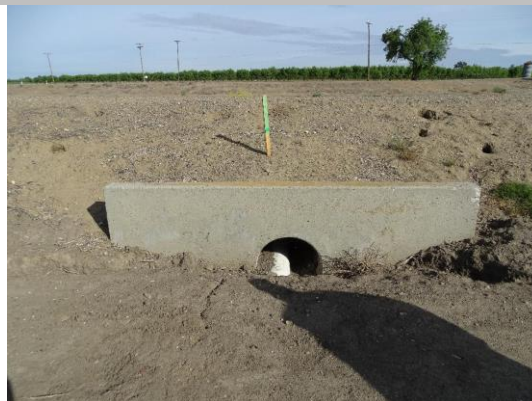
Photo 3 of 3 : UCIP_FA_2022_74658_111525.jpg

LS view: Concrete headwall and pipe inlet; PVC pipe was inserted into the draining pipe inlet.

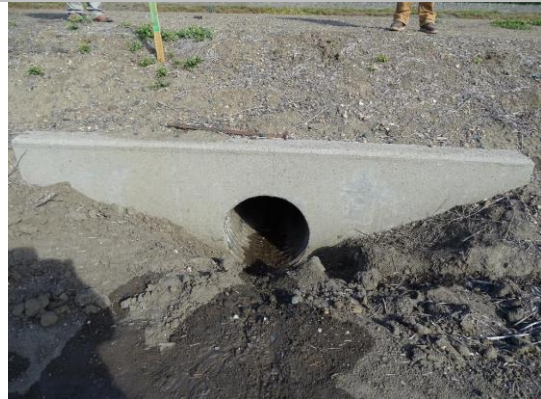
Photo 1 of 2 : UCIP_FA_2022_74630_111540.jpg

Comment Code						
Inspector Comment						
DS_ID:23070 FS_ID:74630 EP_NO: N/A Repair Type: Non-Urgent EVAL Issue: 5, Pipe Damage Crossing Status: Found UCIP Comments: 04/14/2022 Record remains Non-Urgent. DMP internal video inspection has found pipe integrity issues. LOF of crossing is greater than or equal to 4.1 and less than 5. Crossing will be monitored until funding becomes available for rehabilitation. Pipe on LS and WS have been cleared, but sediment buildup is present on spillway on WS. The sediment buildup does not currently impact operation of flap gate. (M.Thao - DWR UCIP) 09/29/2016: WS and LS ends have been cleared by Mike Walejko of NA0013. Crossing will be downgraded from Non-Urgent to No Action Needed upon receipt of photo showing cleared LS inlet. (K. Fazel - UCIP)09/2013:- needs vegetation clearing on waterside.- inlet on landside needs clearing. (P. Amatya - UCIP) FIELD_STRUCT_DESC: 24-inch corrugated metal gravity drainage pipe through the levee, 6 feet below the crown. Concrete headwall, flap gate, and concrete grouted cobble spillway on the waterside (WS) toe. Concrete headwall on the landside (LS) toe. [Additional Reference(s): DWR Levee Log, 2005 (HLM 0.31) . USACE San Joaquin O&M Manual 607, June 1962, (HLM 0.31), listed as 24-inch pipe]. FS Date: 4/14/2022

LS view: Concrete headwall and pipe inlet on toe.

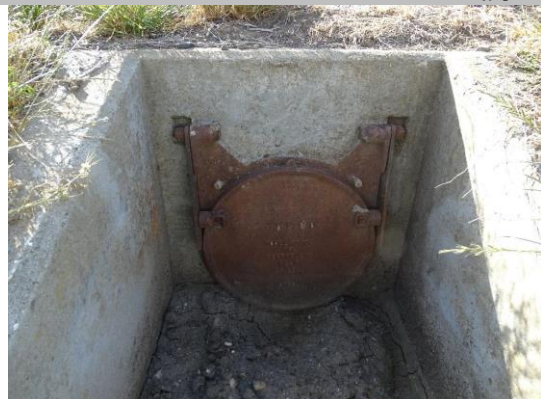
Photo 2 of 2 : UCIP_FA_2022_74630_111537.jpg

WS view: Close-up view on flap gate not impacted by sediment buildup.

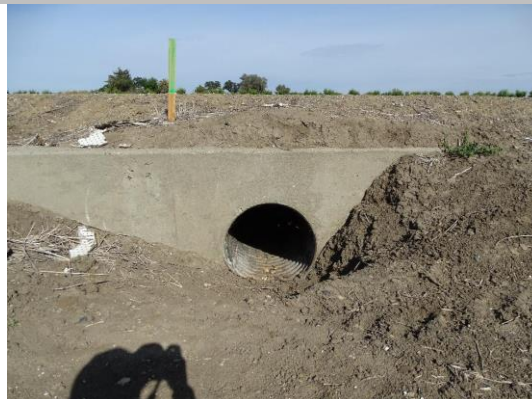
Photo 1 of 2 : UCIP_FA_2022_74632_111547.jpg

Comment Code					
Inspector Comment					
DS_ID:23071 FS_ID:74632 EP_NO: N/A Repair Type: Non-Urgent EVAL Issue: 5, Pipe Damage Crossing Status: Found UCIP Comments: 04/14/2022 Record updated from No Action Needed to Non-Urgent. DMP internal video inspection has found pipe integrity issues. LOF of crossing is greater than or equal to 4.1 and less than 5. Crossing will be monitored until funding becomes available for rehabilitation. (M.Thao - DWR UCIP) 09/29/2016: WS headwall, flap gate and spillway have been cleared of vegetation by Mike Walejko of NA0013. Crossing has been downgraded from Non-Urgent to No Action Needed. (K. Fazel - UCIP)09/2013:- vegetations clearing on spillway area. (P. Amatya - UCIP) FIELD_STRUCT_DESC: 24-inch corrugated metal gravity drainage pipe through the levee, 5 feet below the crown. Concrete headwall, flap gate, and concrete grouted cobble spillway on the waterside (WS) toe. Concrete headwall on the landside (LS) toe. [Additional Reference(s): DWR Levee Log, 2005 (HLM 0.45). USACE San Joaquin O&M Manual 607, June 1962, (HLM 0.45), listed as 24-inch pipe]. FS Date: 4/14/2022

LS view: Concrete headwall and pipe inlet on toe.

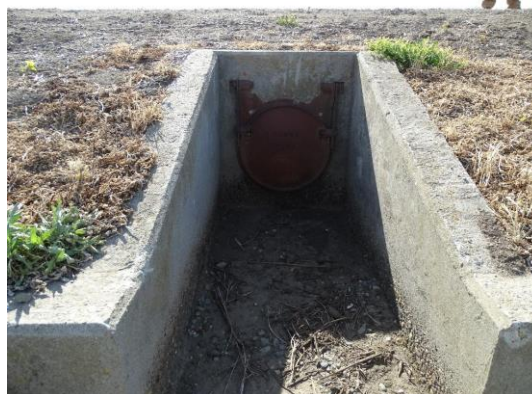
Photo 2 of 2 : UCIP_FA_2022_74632_111548.jpg

WS view: Concrete headwall, spillway, and flap gate on toe.

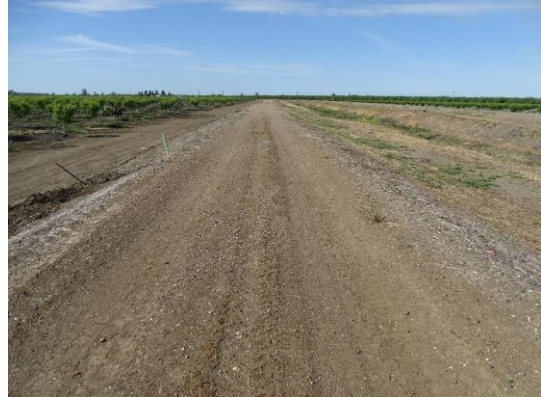
Photo 1 of 3 : UCIP_FA_2022_74659_111555.jpg

DS_ID:23072
FS_ID:74659
EP_NO: N/A
Repair Type: Non-Urgent
EVAL Issue: 5, Pipe Damage
Crossing Status: Found
UCIP Comments: 04/14/2022 Record remains Non-Urgent. DMP internal video inspection has found pipe integrity issues. LOF of crossing is greater than or equal to 4.1 and less than 5. Crossing will be monitored until funding becomes available for rehabilitation. The headwall and pipe inlet was not found on LS toe. Need to coordinate with LMA to determine status of crossing. (M.Thao - DWR UCIP)
09/29/2016: WS cleared by NA0013. Crossing will be downgraded from Non-Urgent to No Action Needed upon receipt of photo showing cleared LS inlet. (K. Fazel - UCIP)
09/2013:- needs vegetation clearing on both levee sides. (P. Amatya - UCIP)
FIELD_STRUCT_DESC: 24-inch corrugated metal gravity drainage pipe through the levee, 6 feet below the crown. Concrete headwall, flap gate, and concrete grouted cobble spillway on the waterside (WS) toe. Concrete headwall on the landside (LS) toe. [Additional Reference(s): DWR Levee Log, 2005 (HLM 0.58). USACE San Joaquin O&M Manual 607, June 1962, (HLM 0.58), listed as 24-inch pipe].

Levee crown looking downstream.

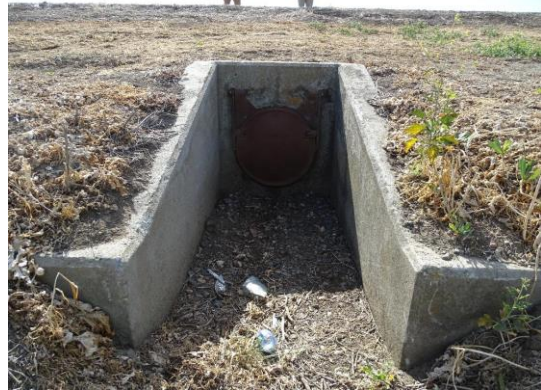
Photo 3 of 3 : UCIP_FA_2022_74659_111558.jpg

WS view: Concrete headwall, spillway, and flap gate on toe.

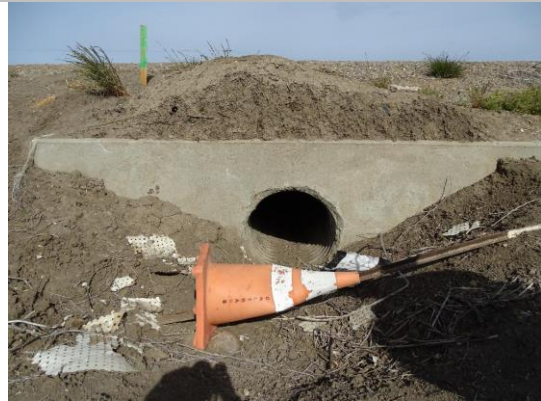
Photo 1 of 3 : UCIP_FA_2022_74660_111561.jpg

DS_ID:23073
 FS_ID:74660
 EP_NO: N/A
 Repair Type: Urgent
 EVAL Issue: 2b, Levee Integrity
 Crossing Status: Found
 UCIP Comments: 04/14/2022 Record updated from Non-Urgent to Urgent. Levee disturbance caused by erosion is greater than 1/2 foot in depth around concrete headwall on WS toe. DMP internal video inspection has found pipe integrity issues. LOF of crossing is greater than or equal to 4.1 and less than 5. Crossing will be monitored until funding becomes available for rehabilitation. (M.Thao - DWR UCIP) 09/17/2013 - needs vegetation clearing on waterside.- concrete spillway on waterside.- the drainage was working during field survey. (DWR UCIP - P. Amatya)
 FIELD_STRUCT_DESC: 24-inch corrugated metal gravity drainage pipe through the levee, 6 feet below the crown. Concrete headwall, flap gate, and concrete grouted cobble spillway on the waterside (WS) toe. Concrete headwall on the landside (LS) toe. [Additional Reference(s): DWR Levee Log, 2005 (HLM 0.81). USACE San Joaquin O&M Manual 607, June 1962, (HLM 0.82), listed as 24-inch pipe].

LS view: Concrete headwall and pipe inlet on toe.

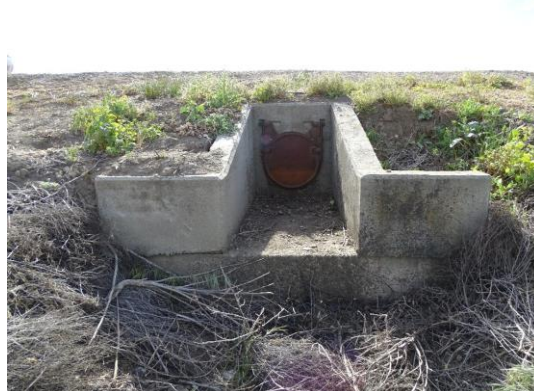
Photo 2 of 3 : UCIP_FA_2022_74660_111562.jpg

WS view: Concrete headwall, spillway, and flap gate on toe.

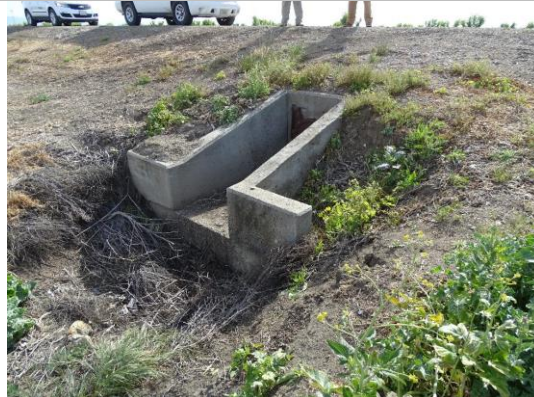
Photo 3 of 3 : UCIP_FA_2022_74660_111563.jpg

WS view: Erosion present around concrete headwall.

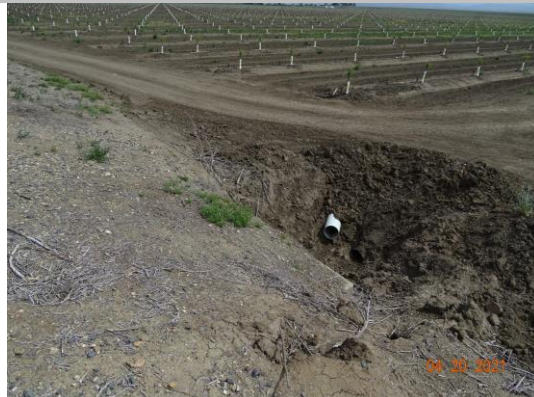
Photo 1 of 1 : FA_2022_NA0013_334_13_20220822_00003.jpg

LM Start	1.01	Rating **	M	Issue No.	13
LM End	1.01	Issue Type +	En	Location *	LS
Category	Earthen Levee			GPS Latitude/Longitude	
				Start	End
Item	Encroachments			37.263139 °	37.263139 °
				-120.287799 °	-120.287799 °
DWR ID	DWR_NA0013_04_s_2021_13				
Comment Code					
PI : Pipe					
Inspector Comment					
There appears to be installed drainage pipes feeding the existing pipe crossing. There is no known permit related to these pipes.

Drainage pipes feeding to existing pipe crossing. (Spring 2021)

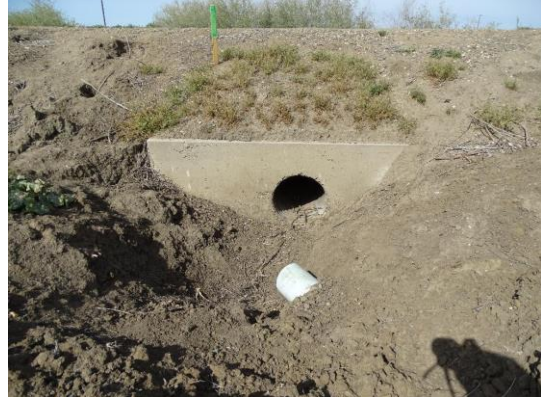
Photo 1 of 2 : UCIP_FA_2022_74642_111566.jpg

Comment Code					
Inspector Comment					
DS_ID:23074 FS_ID:74642 EP_NO: N/A Repair Type: Non-Urgent EVAL Issue: 5, Pipe Damage Crossing Status: Found UCIP Comments: 04/14/2022 Record updated from No Action Needed to Non-Urgent. DMP internal video inspection has found pipe integrity issues. LOF of crossing is greater than or equal to 4.1 and less than 5. Crossing will be monitored until funding becomes available for rehabilitation. Appears two PVC pipes have been placed landward off levee toe and covered with fill; no modifications to crossing observed. The PVC pipes now drain to the crossing. (M.Thao - DWR UCIP) 09/17/2013 - concrete spillway on waterside.- drainage was working during field survey (DWR UCIP - P. Amatya). FIELD_STRUCT_DESC: 24-inch corrugated metal gravity drainage pipe through the levee, 8 feet below the crown. Concrete headwall, flap gate, and concrete grouted cobble spillway on the waterside (WS) toe. Concrete headwall on the landside (LS) toe. [Additional Reference(s): DWR Levee Log, 2005 (HLM 1.02). USACE San Joaquin O&M Manual 607, June 1962, (HLM 1.02), listed as 24-inch pipe]. FS Date: 4/14/2022

LS view: Concrete headwall and pipe inlet on toe.

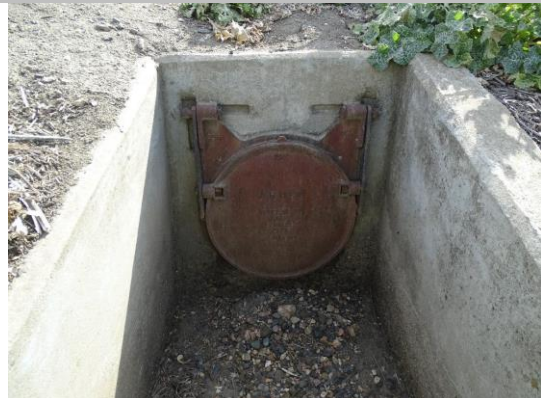
Photo 2 of 2 : UCIP_FA_2022_74642_111568.jpg

WS view: Concrete headwall, spillway, and flap gate on toe.

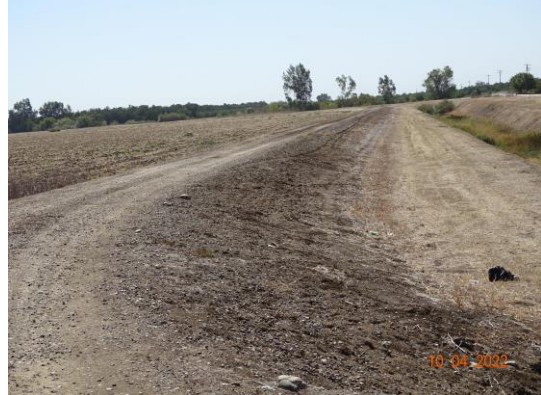
Photo 1 of 1 : FA_2022_NA0013_334_15_20221020_00006.jpg

LM Start	1.07	Rating **	A	Issue No.	15
LM End	1.07	Issue Type +	Ma	Location *	WS
Category	Earthen Levee			GPS Latitude/Longitude	
				Start	End
Item	Vegetation			37.262366 °	37.262366 °
				-120.288252 °	-120.288252 °
DWR ID	DWR_NA0013_04_f_2022_15				
Comment Code					
V1 : Control annual grass and weeds on the levee slopes and easements.					
Inspector Comment					
The annual vegetation is well maintained.

View of vegetation management on the waterside slope. (Fall 2022)

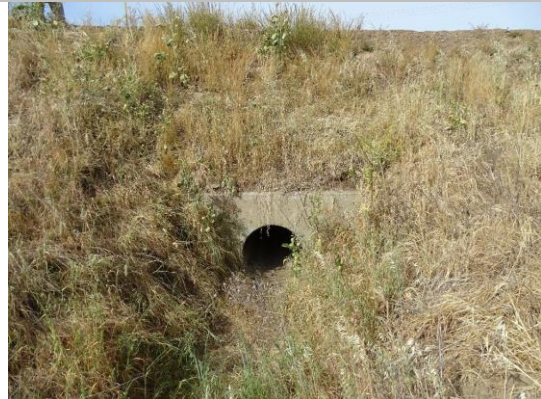
Photo 1 of 2 : UCIP_FA_2022_74643_111570.jpg

Comment Code						
Inspector Comment						
DS_ID:23075 FS_ID:74643 EP_NO: N/A Repair Type: Non-Urgent EVAL Issue: 5, Pipe Damage Crossing Status: Found UCIP Comments: 04/14/2022 Record remains Non-Urgent. DMP internal video inspection has found pipe integrity issues. LOF of crossing is greater than or equal to 4.1 and less than 5. Crossing will be monitored until funding becomes available for rehabilitation. No issues observed during inspection. (M.Thao - DWR UCIP) 09/17/2013 - needs clearing on both inlet and outlet. - needs vegetations clearing on spillway on waterside and inlet on landside. (DWR UCIP - P. Amatya) FIELD_STRUCT_DESC: 24-inch corrugated metal gravity drainage pipe through the levee, 10 feet below the crown. Concrete headwall, flap gate, and concrete grouted cobble spillway on the waterside (WS) toe. Concrete headwall on the landside (LS) toe. [Additional Reference(s): DWR Levee Log, 2005 (HLM 1.08). USACE San Joaquin O&M Manual 607, June 1962, (HLM 1.08), listed as 24-inch pipe]. FS Date: 4/14/2022

LS view: Concrete headwall and pipe inlet on toe.

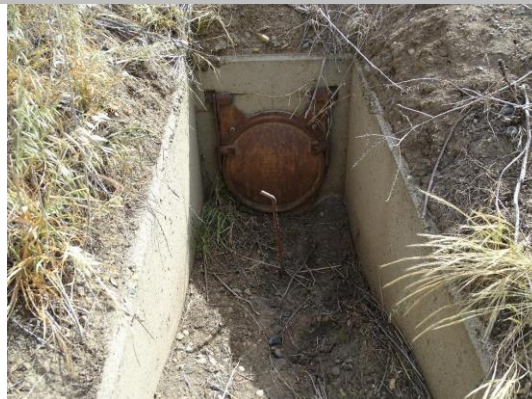
Photo 2 of 2 : UCIP_FA_2022_74643_111572.jpg

WS view: Concrete headwall, spillway, and flap gate on toe.

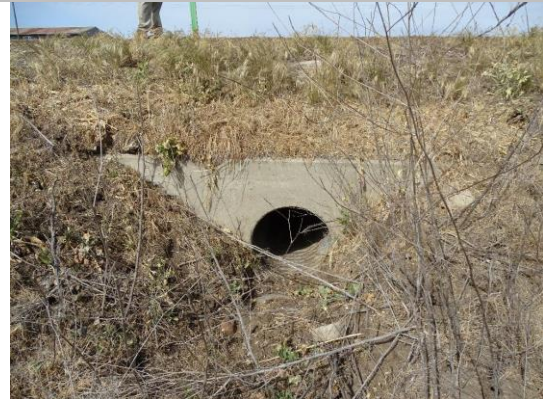
Photo 1 of 2 : UCIP_FA_2022_74650_111587.jpg

DS_ID:23076
FS_ID:74650
EP_NO: N/A
Repair Type: Non-Urgent
EVAL Issue: 5, Pipe Damage
Crossing Status: Found
UCIP Comments: 04/14/2022 Record updated from No Action Needed to Non-Urgent. DMP internal video inspection has found pipe integrity issues. LOF of crossing is greater than or equal to 4.1 and less than 5. Crossing will be monitored until funding becomes available for rehabilitation. No issues observed during inspection. (M.Thao - DWR UCIP)
09/01/2016: Per Mike Walejko, WS outlet has been cleared. See photos. Crossing has been downgraded from Urgent to No Action Needed. (K. Fazel - UCIP)08/23/2016: LS inlet is clear. WS outlet is still buried. Cracks on crown characteristic of entire left bank and not associated with the crossing at this location. (K. Fazel - UCIP)09/17/2013:- significant levee crown and slope cracks along the pipe. Detailed investigation required.- inlet pipe buried on landside. Needs removal of silts. Needs clearing and cleaning.- half of outlet pipe buried. Needs clearing and removal of vegetations and silts. (P. Amatya - UCIP)

LS view: Concrete headwall and pipe inlet at toe.

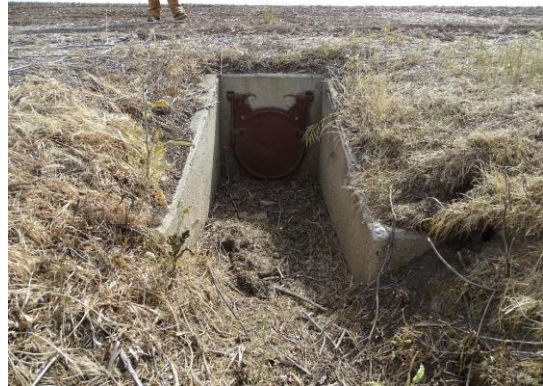
Photo 2 of 2 : UCIP_FA_2022_74650_111588.jpg

WS view: Concrete headwall, spillway, and flap gate on toe.
