**Flood Control Project Maintenance
Levee Inspections
Fall 2023 Levee Maintenance Deficiency Summary Report**

San Joaquin River Basin

| NA0013 | Overall LMA Rating | Total LMA Miles | | | | | | |

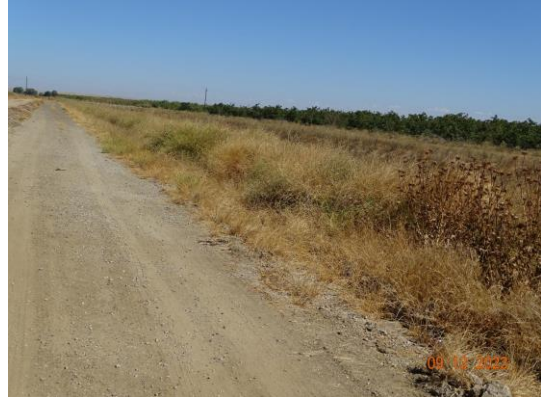
Photo 1 of 1 : FA_2023_NA0013_331_2_20231102_00009.jpg

View of vegetation on the waterside slope. (Fall 2023)

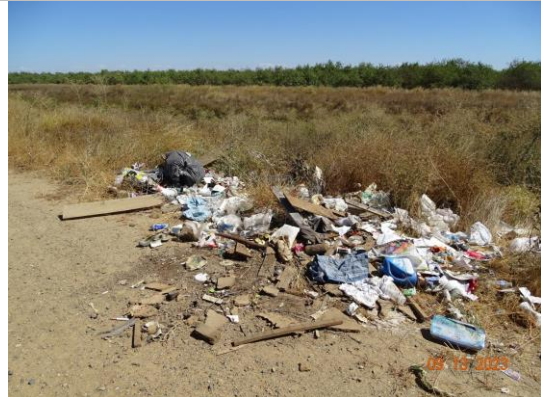
Photo 1 of 1 : FA_2023_NA0013_331_9_20230925_00008.jpg

View of garbage left on the waterside shoulder. (Fall 2023)

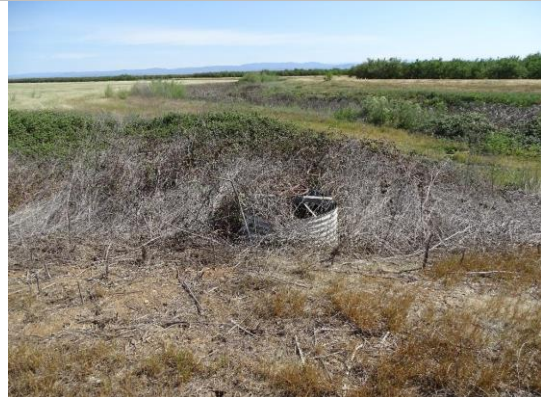
Photo 1 of 2 : UCIP_FA_2023_74566_111342.jpg

DS_ID:23079
FS_ID:74566
EP_NO: N/A
Repair Type: Non-Urgent
EVAL Issue: 4b, Safety Issue
Crossing Status: Found
UCIP Comments: 04/13/2022 Record remains Non-Urgent. Overgrown vegetation limits inspection of levee at this crossing; recommend removing vegetation. Geophysical study indicates possible presence of pipe through levee. Cover on CMP riser is missing causing a safety hazard. Crossing appears abandoned. Owner needs to coordinate with the CVFPB to remove or abandon crossing according to Title 23 requirements. Coordinates have been updated from 37.332805, -120.394906 to 37.332826, -120.394886. (M.Thao - DWR UCIP) 09/17/2013 Verify Pipe is abandoned or still intact.- may be this crossing was abandoned/removed during recent levee reconstruction.- no signs of pipe and appurtenances on waterside.- only a CM pipe riser with slide gate found on landside. (DWR UCIP - P. Amatya)
FIELD_STRUCT_DESC: 36-inch corrugated metal irrigation pipe through the levee, 10 feet below the crown. Riser on the landside (LS). Screw gate in a 48-inch pipe well on the waterside (WS) slope. Concrete headwall and cobble apron at the LS toe. Concrete headwall at the WS toe. [Additional Reference(s): USACE San Joaquin O&M Manual 607, June 1962, (HLM 1.32), listed as 36-inch pipe].

WS view: Looking from crown; slide gate in CMP riser. Dense vegetation.

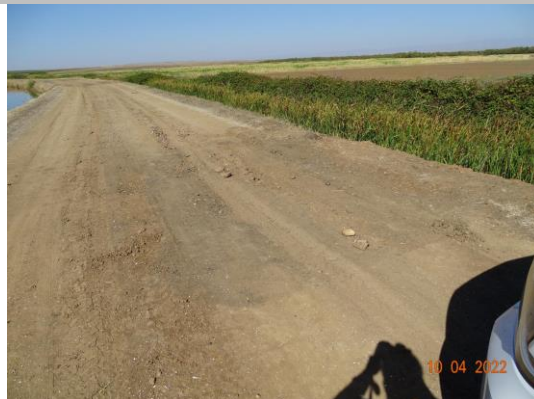
Photo 1 of 1 : FA_2023_NA0013_331_12_20230821_00004.jpg

Depression in the levee crown should be backfilled. (Fall 2022)

| C2 : Repair depressions or ruts in the crown or slope. | | | | | |

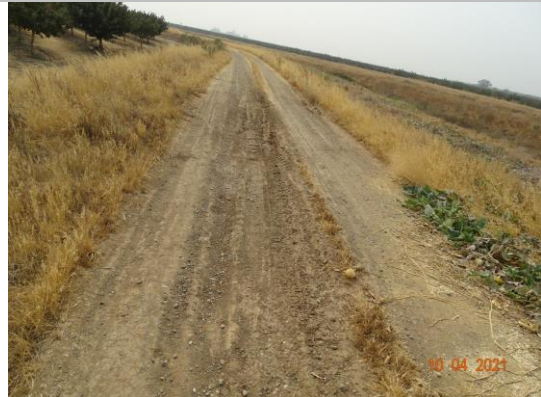
Photo 1 of 1 : FA_2023_NA0013_332_27_20230821_00012.jpg

View of depressions in the levee crown from vehicle traffic. (Fall 2021)

| C2 : Repair depressions or ruts in the crown or slope. | | | | | |

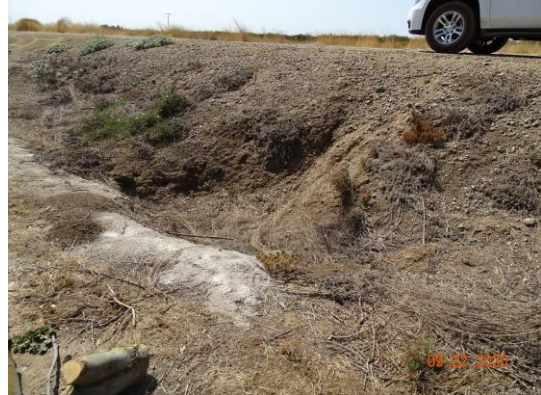
Photo 1 of 1 : FA_2023_NA0013_332_28_20230821_00013.jpg

View of erosion pocket in the landside slope and toe. (Fall 2020)

| E2 : Schedule repair of erosion site prior to the next inspection. | | | | | |

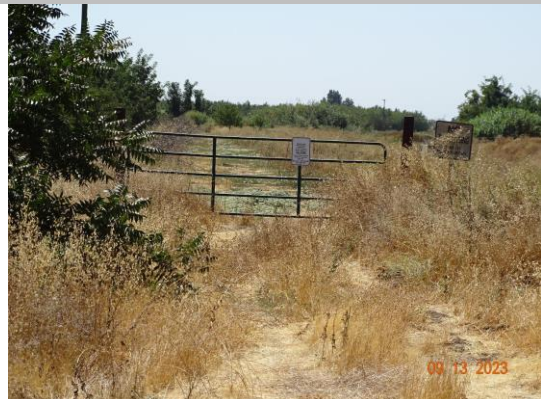
Photo 1 of 1 : FA_2023_NA0013_332_29_20230925_00018.jpg

View of annual vegetation growing along the levee crown. (Fall 2023)

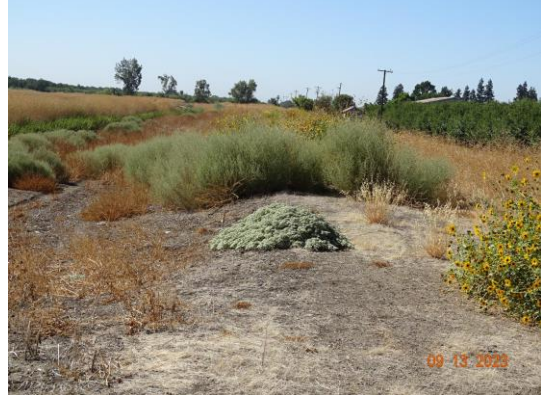
Photo 1 of 1 : FA_2023_NA0013_333_10_20230925_00005.jpg

View of vegetation growing along the levee crown. (Fall 2023)

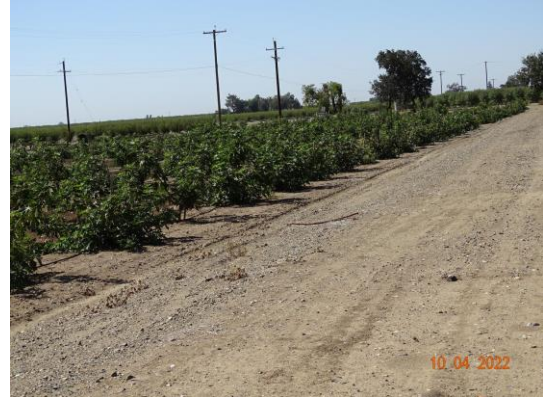
Photo 1 of 1 : FA_2023_NA0013_334_16_20230821_00005.jpg

Crops planted within the easement of the landside toe. (Fall 2022)

| Crops plants approximately 5 ft from landside toe should be move outside the 20 ft easement. | | | | | |

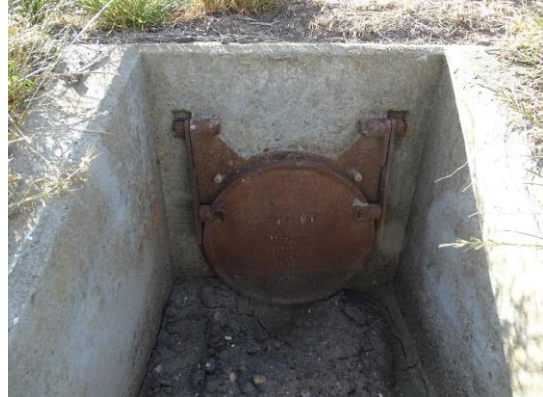
Photo 2 of 2 : UCIP_FA_2023_74630_111537.jpg

| DS_ID:23070 FS_ID:74630 EP_NO: N/A Repair Type: No Action Needed EVAL Issue: Crossing Status: Found UCIP Comments: 09/18/2023 Record updated from Non-Urgent to No Action Needed. Pipe was CIPP lined. DMP internal video inspection has found none or minor pipe defects. Recommend next video inspection in 5 years. (O. Yakimov - DWR UCIP) 04/14/2022 Record remains Non-Urgent. DMP internal video inspection has found pipe integrity issues. LOF of crossing is greater than or equal to 4.1 and less than 5. Crossing will be monitored until funding becomes available for rehabilitation. Pipe on LS and WS have been cleared, but sediment buildup is present on spillway on WS. The sediment buildup does not currently impact operation of flap gate. (M.Thao - DWR UCIP) 09/29/2016: WS and LS ends have been cleared by Mike Walejko of NA0013. Crossing will be downgraded from Non-Urgent to No Action Needed upon receipt of photo showing cleared LS inlet. (K. Fazel - UCIP)09/2013:- needs vegetation clearing on waterside.- inlet on landside needs clearing. (P. Amatya - UCIP) FIELD_STRUCT_DESC: 24-inch CIPP-lined corrugated metal gravity drainage pipe through the levee, 6 feet below the crown. Concrete headwall, flap gate, and concrete grouted cobble spillway on the waterside (WS) toe. Concrete headwall on the landside (LS) toe. [Additional Reference(s): DWR Levee Log, 2005 (HLM 0.31) . USACE San Joaquin O&M Manual 607, June 1962, (HLM 0.31), listed as 24-inch pipe]. FS Date: 4/14/2022 | | | | | | |

WS view: Close-up view on flap gate not impacted by sediment buildup.

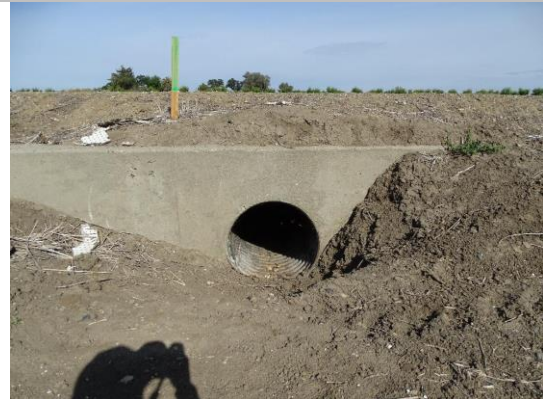
Photo 1 of 2 : UCIP_FA_2023_74632_111547.jpg

LS view: Concrete headwall and pipe inlet on toe.

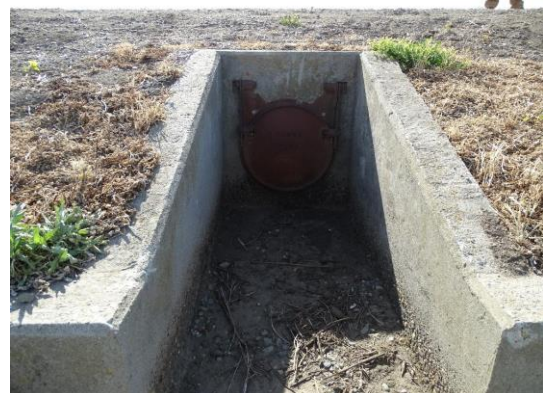
Photo 2 of 2 : UCIP_FA_2023_74632_111548.jpg

WS view: Concrete headwall, spillway, and flap gate on toe.

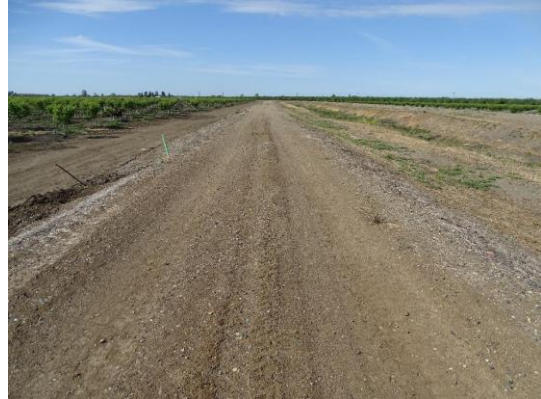
Photo 1 of 3 : UCIP_FA_2023_74659_111555.jpg

Levee crown looking downstream.

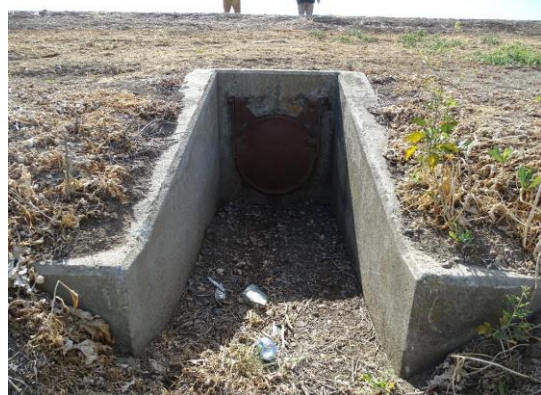
Photo 3 of 3 : UCIP_FA_2023_74659_111558.jpg

WS view: Concrete headwall, spillway, and flap gate on toe.

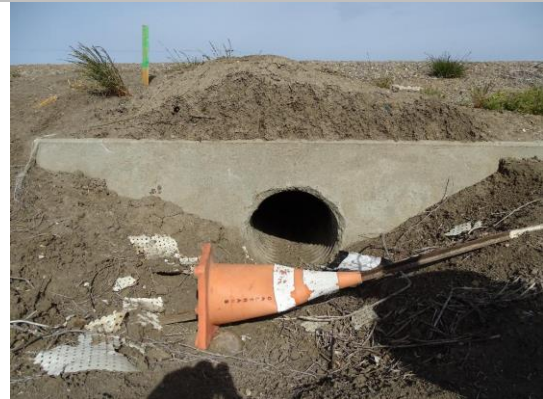
Photo 1 of 3 : UCIP_FA_2023_74660_111561.jpg

LS view: Concrete headwall and pipe inlet on toe.

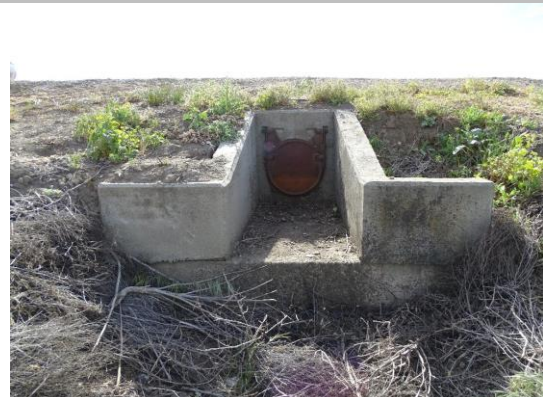
Photo 2 of 3 : UCIP_FA_2023_74660_111562.jpg

WS view: Concrete headwall, spillway, and flap gate on toe.

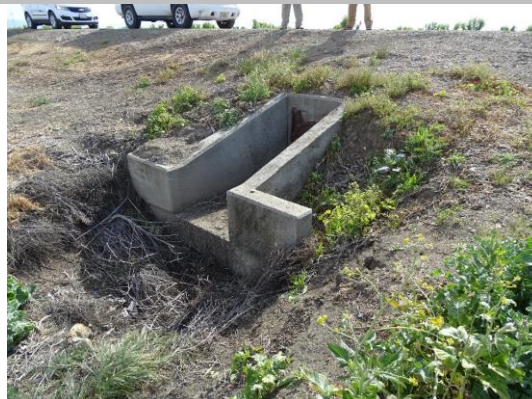
Photo 3 of 3 : UCIP_FA_2023_74660_111563.jpg

WS view: Erosion present around concrete headwall.

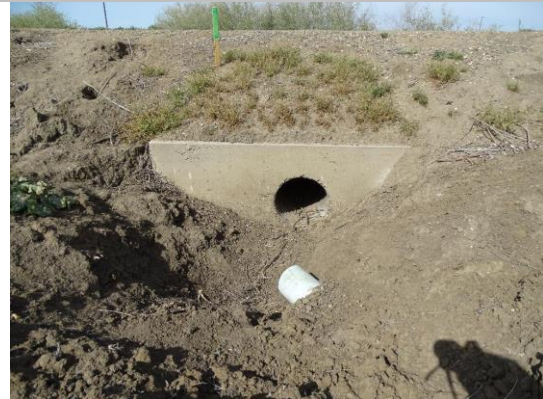
Photo 1 of 2 : UCIP_FA_2023_74642_111566.jpg

LS view: Concrete headwall and pipe inlet on toe.

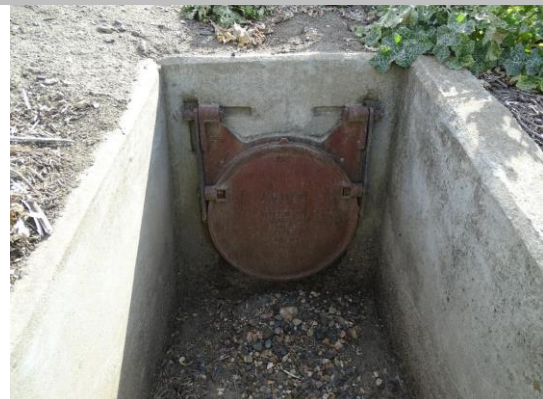
Photo 2 of 2 : UCIP_FA_2023_74642_111568.jpg

WS view: Concrete headwall, spillway, and flap gate on toe.

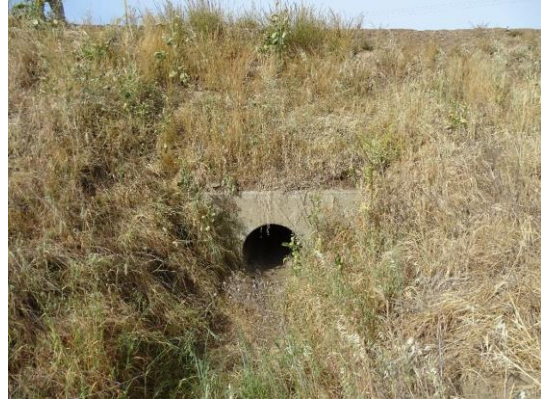
Photo 1 of 2 : UCIP_FA_2023_74643_111570.jpg

LS view: Concrete headwall and pipe inlet on toe.

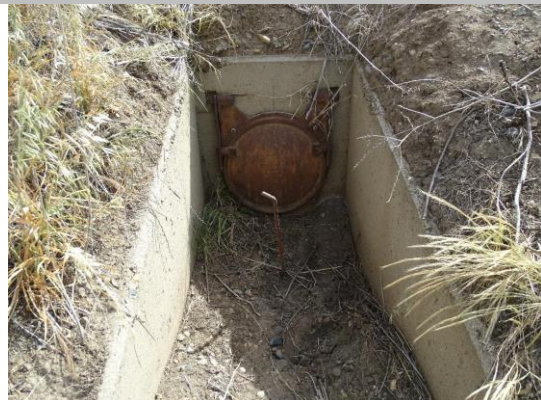
Photo 2 of 2 : UCIP_FA_2023_74643_111572.jpg

WS view: Concrete headwall, spillway, and flap gate on toe.

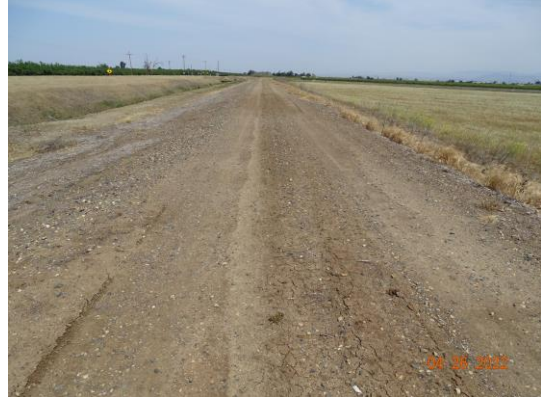
Photo 1 of 1 : FA_2023_NA0013_334_14_20230821_00004.jpg

Depressions beginning to form in the levee crown from vehicle traffic.
(Spring 2022)

| C2 : Repair depressions or ruts in the crown or slope. | | | | | |
| Minor rutting in the levee crown should be filled and compacted before rutting worsens. | | | | | |

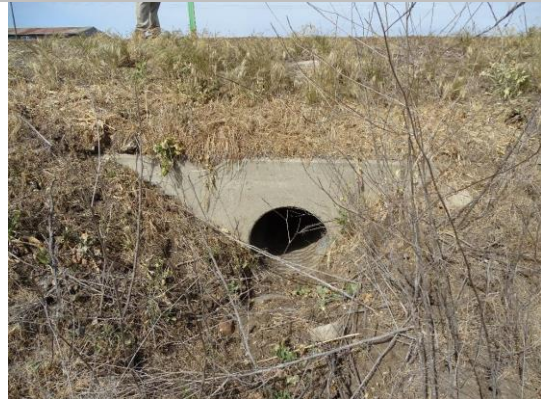
Photo 1 of 2 : UCIP_FA_2023_74650_111587.jpg

LS view: Concrete headwall and pipe inlet at toe.
