Flood Control Project Maintenance Levee Inspections

Fall 2024 Levee Maintenance Deficiency Summary Report

San Joaquin River Basin

Merced Streams Group

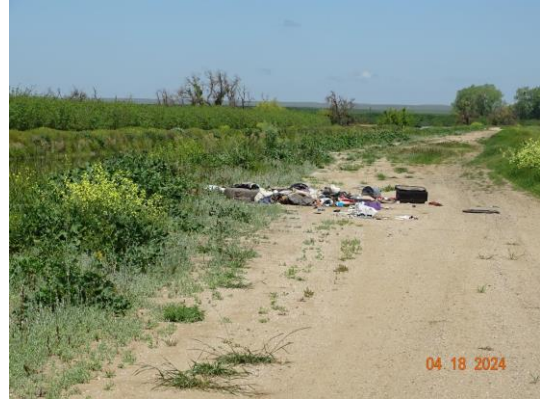
Photo 1 of 1 : FA_2024_NA0013_331_17_20240828_00006.jpg

LM Start	0.71	Rating **	M	Issue No.	17
LM End	0.71	Issue Type +	Ma	Location *	CR
Category	Earthen Levee			GPS Latitude/Longitude	
				Start	End
Item	Encroachments			37.324896 °	37.324896 °
				-120.396659 °	-120.396659 °
DWR ID	DWR_NA0013_01_s_2024_17				
Comment Code					
GA : Garbage					
Inspector Comment

Garbage dumped on the levee crown and landside shoulder. (Spring 2024)

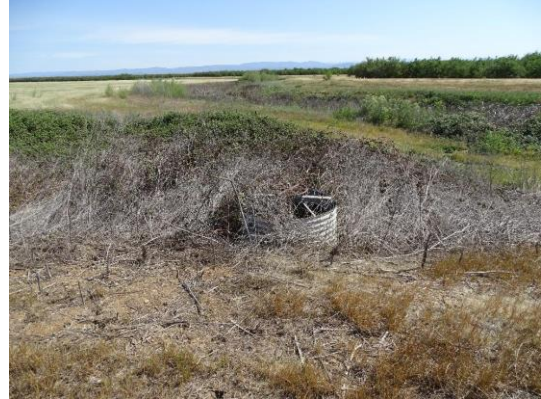
Photo 1 of 2 : UCIP_FA_2024_74566_111342.jpg

DS_ID:23079
FS_ID:74566
EP_NO: N/A
Repair Type: Non-Urgent
EVAL Issue: 4b, Safety Issue
Crossing Status: Found
UCIP Comments: 04/13/2022 Record remains Non-Urgent. Overgrown vegetation limits inspection of levee at this crossing; recommend removing vegetation. Geophysical study indicates possible presence of pipe through levee. Cover on CMP riser is missing causing a safety hazard. Crossing appears abandoned. Owner needs to coordinate with the CVFPB to remove or abandon crossing according to Title 23 requirements. Coordinates have been updated from 37.332805, -120.394906 to 37.332826, -120.394886. (M.Thao - DWR UCIP) 09/17/2013 Verify Pipe is abandoned or still intact may be this crossing was abandoned/removed during recent levee reconstruction. no signs of pipe and appurtenances on waterside only a CM pipe riser with slide gate found on landside. (DWR UCIP - P. Amatya)
FIELD_STRUCT_DESC: 36-inch corrugated metal irrigation pipe through the levee, 10 feet below the crown. Riser on the landside (LS). Screw gate in a 48-inch pipe well on the waterside (WS) slope. Concrete headwall and cobble apron at the LS toe. Concrete headwall at the WS toe. [Additional Reference(s): USACE San Joaquin O&M Manual 607, June 1962, (HLM 1.32), listed as 36-inch pipe].

WS view: Looking from crown; slide gate in CMP riser. Dense vegetation.

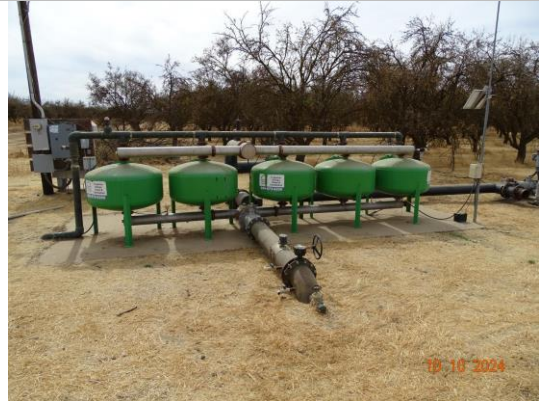
Photo 1 of 1 : FA_2024_NA0013_332_2_20241011_00031.jpg

LM Start	0.00	Rating **	U	Issue No.	2
LM End	0.00	Issue Type +	En	Location *	LS
Category	Earthen Levee			GPS Latitude/Longitude	
				Start	End
Item	Encroachments			37.337034 °	37.337034 °
				-120.387422 °	-120.387422 °
DWR ID	DWR_NA0013_02_f_2012_2				
Comment Code					
PI : Pipe					
Inspector Comment					
There is no CVFPB permit on record for this issue. Merced County Flood Control is aware of this issue.

Tank and filtration system installed on the landside easement. (Fall 2024)

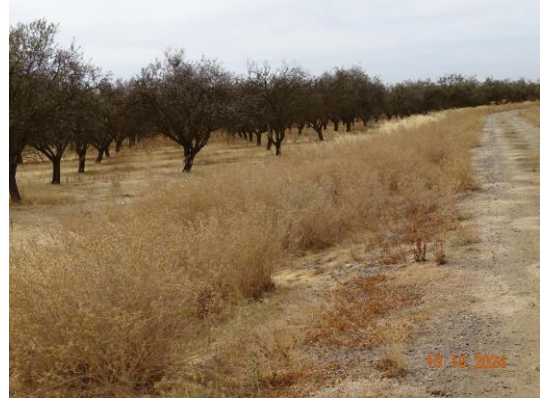
Photo 1 of 1 : FA_2024_NA0013_332_25_20241011_00033.jpg

LM Start	0.04	Rating **	M	Issue No.	25
LM End	0.93	Issue Type +	Ma	Location *	LS
Category	Earthen Levee			GPS Latitude/Longitude	
				Start	End
Item	Vegetation			37.336901 °	37.327920 °
				-120.387969 °	-120.396098 °
DWR ID	DWR_NA0013_02_f_2024_25				
Comment Code					
V1 : Control annual grass and weeds on the levee slopes and easements.					
Inspector Comment

View of vegetation on the landside slope. (Fall 2024)

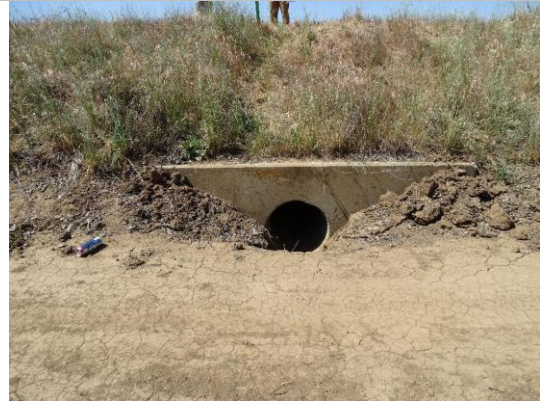
Photo 1 of 2 : UCIP_FA_2024_77955_111386.jpg

LS view: Concrete headwall and pipe inlet at toe.

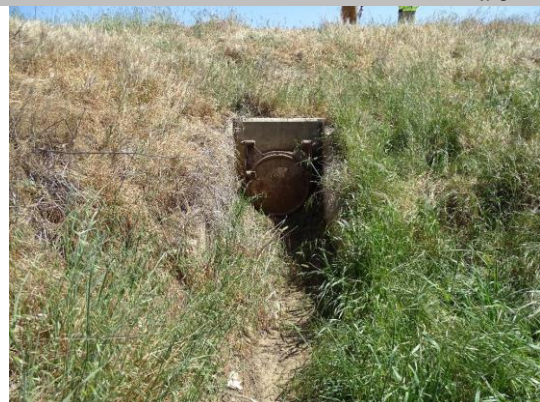
Photo 2 of 2 : UCIP_FA_2024_77955_111388.jpg

WS view: Concrete headwall and flap gate on toe.

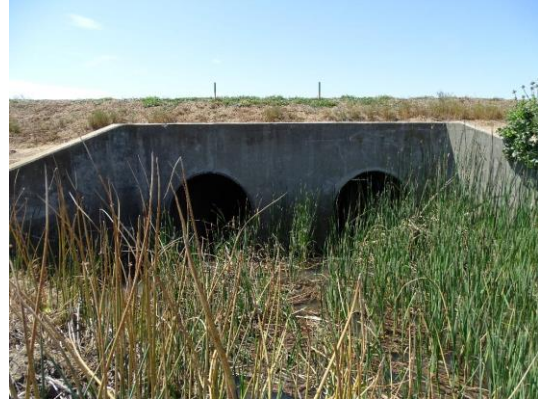
Photo 1 of 2 : UCIP_FA_2024_77956_111398.jpg

Comment Code						
Inspector Comment						
DS_ID:23056 FS_ID:77956 EP_NO: N/A Repair Type: No Action Needed EVAL Issue: Crossing Status: Found UCIP Comments: 12/20/2022 Record updated from Urgent to No Action Needed. Pipe has been CIPP lined. LOF of crossing is less or equal to 4. Recommend next video inspection in 5 years. (O.Yakimov - DWR UCIP) 04/13/2022 Record remains Urgent. DMP internal video inspection has found pipe integrity issues. LOF of crossing is greater than or equal to 5 and less than 6. Crossing will be monitored until funding becomes available to address the issues. (M.Thao - DWR UCIP) 04/13/2022 Record remains Urgent. DMP internal video inspection has found pipe integrity issues. LOF of crossing is equal to 5 and less than 6. Crossing will be monitored until funding becomes available to address the issues. (M.Thao - DWR UCIP) 09/17/2013 - working during field inspection.vegetation on drainage ditch/channel (DWR UCIP - P. Amatya) FIELD_STRUCT_DESC: 1 of 2: 60-inch CIPP-lined corrugated metal drainage culvert through the levee, 10 feet below the crown. Concrete headwall and flap gate on the waterside (WS) berm, 5 feet from the levee toe. Concrete headwall on the landside (LS) toe. [Additional Reference(s): DWR Levee Log, 2005 (HLM 0.91). USACE San Joaquin O&M Manual 607, June 1962, Revised March 1984, (HLM 0.91), listed as 60-inch pipe]. FS Date: 4/13/2022 11:16:23 AM

LS view: Concrete headwall and pipe inlet.

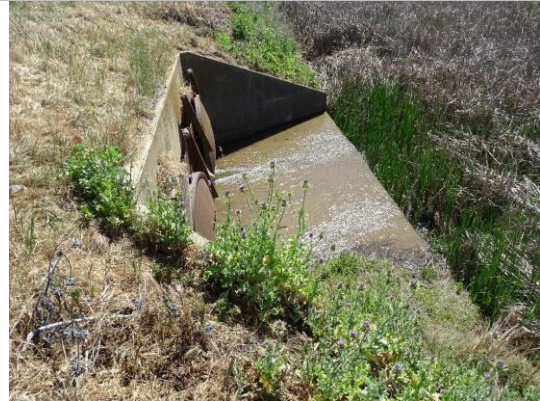
Photo 2 of 2 : UCIP_FA_2024_77956_111395.jpg

WS view: Concrete headwall, apron, and flap gate on channel bank.

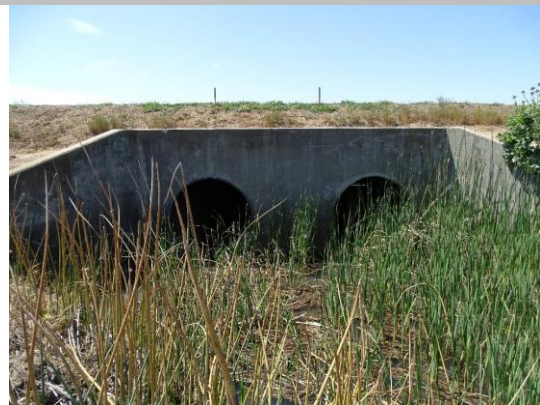
Photo 1 of 2 : UCIP_FA_2024_77957_111404.jpg

DS_ID:23080
 FS_ID:77957
 EP_NO: N/A
 Repair Type: No Action Needed
 EVAL Issue:
 Crossing Status: Found
 UCIP Comments: 12/20/2022 Record updated from Urgent to No Action Needed. Pipe has been CIPP lined. LOF of crossing is less or equal to 4. Recommend next video inspection in 5 years. (O.Yakimov - DWR UCIP)
 04/13/2022 Record remains Urgent. DMP internal video inspection has found pipe integrity issues. LOF of crossing is greater or equal to 5 and and less than 6. Crossing will be monitored until funding becomes available to address the issues. (M.Thao - DWR UCIP)
 09/17/2013 It was working during field inspection Dense vegetation in drainage ditch (DWR UCIP - P. Amatya).
 FIELD_STRUCT_DESC: 2 of 2: 60-inch CIPP-lined corrugated metal drainage culvert through the levee, 10 feet below the crown. Concrete headwall and flap gate on the waterside (WS) berm, 5 feet from the levee toe. Concrete headwall on the landside (LS) toe. [Additional Reference(s): DWR Levee Log, 2005 (HLM 0.91). USACE San Joaquin O&M Manual 607, June 1962, Revised March 1984, (HLM 0.91), listed as 60-inch pipe].

LS view: Concrete headwall and pipe inlet.

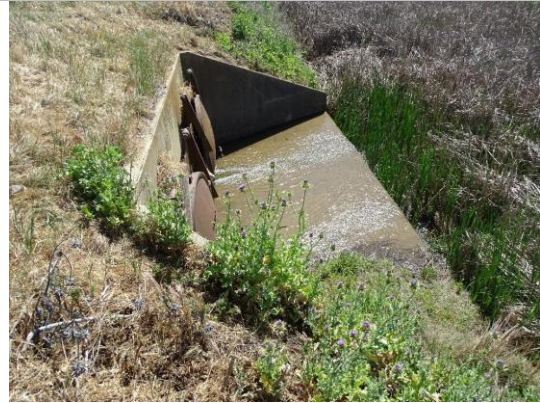
Photo 2 of 2 : UCIP_FA_2024_77957_111405.jpg

WS view: Concrete headwall, apron, and flap gate on channel bank.

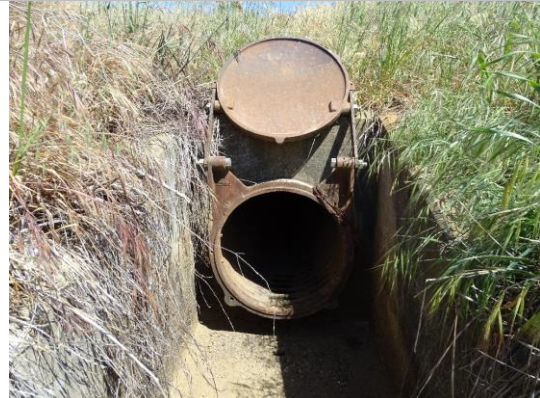
Photo 2 of 3 : UCIP_FA_2024_77958_111411.jpg

WS view: Concrete headwall, apron, and flap gate on toe.

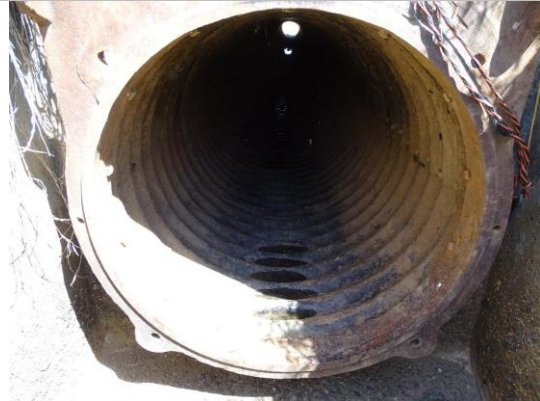
Photo 3 of 3 : UCIP_FA_2024_77958_111421.jpg

WS view: Inside view of pipe outlet; looks clean and clear.

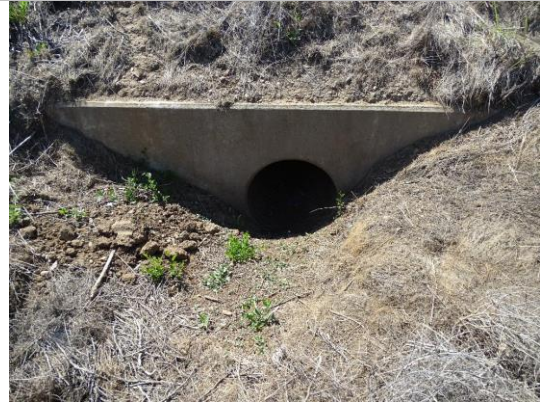
Photo 1 of 2 : UCIP_FA_2024_77959_111432.jpg

Comment Code						
Inspector Comment						
DS_ID:23058 FS_ID:77959 EP_NO: N/A Repair Type: No Action Needed EVAL Issue: Crossing Status: Found UCIP Comments: 09/18/2023 Record updated from Non-Urgent to No Action Needed. Pipe was CIPP lined. DMP internal video inspection has found none or minor pipe defects. Recommend next video inspection in 5 years. (O. Yakimov - DWR UCIP) 04/13/2022 Record remains Non-Urgent. DMP internal video inspection has found pipe integrity issues. LOF of crossing is greater than or equal to 4.1 and less than 5. Crossing will be monitored until funding becomes available for rehabilitation. Debris has deposited at the end of WS apron not allowing water to drainage properly; recommend removing debris. Pipe inlet on LS has been cleared since the last inspection. (M.Thao - DWR UCIP) 09/17/2013 - needs cleaning of debris on spillway on WS. Flapgate blocked by debris on WS. - needs cleaning inside CMP on LS. (DWR UCIP - P. Amatya) FIELD_STRUCT_DESC: 24-inch CIPP-lined corrugated metal gravity drainage pipe through the levee, 8 feet below the crown. Concrete headwall, flap gate, and concrete grouted cobble apron on the waterside (WS) toe. Concrete headwall on the landside (LS) toe. [Additional Reference(s): DWR Levee Log, 2005 (HLM 1.64). USACE San Joaquin O&M Manual 607, June 1962, Revised March 1984, (HLM 1.64), listed as 24-inch pipe]. FS Date: 4/13/2022

LS view: Looking toward levee; concrete headwall and pipe inlet.

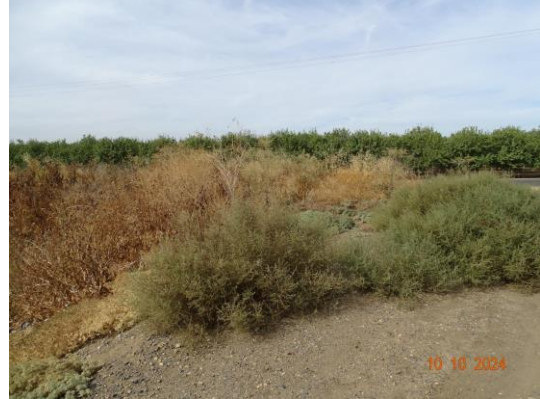
Photo 1 of 1 : FA_2024_NA0013_333_10_20241011_00023.jpg

LM Start	0.00	Rating **	U	Issue No.	10
LM End	0.33	Issue Type +	Ma	Location *	CR
Category	Earthen Levee			GPS Latitude/Longitude	
				Start	End
Item	Vegetation			37.257654 °	37.262423 °
				-120.288501 °	-120.288364 °
DWR ID	DWR_NA0013_03_f _ 2023_10				
Comment Code					
V3 : Keep the crown roadway free of vegetation.					
Inspector Comment

View of levee crown looking downstream. (Fall 2024)

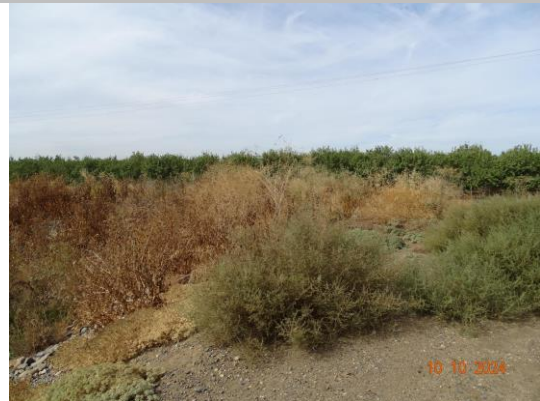
Photo 1 of 1 : FA_2024_NA0013_333_8_20241011_00024.jpg

LM Start	0.00	Rating **	U	Issue No.	8
LM End	0.34	Issue Type +	Ma	Location *	WS
Category	Earthen Levee			GPS Latitude/Longitude	
				Start	End
Item	Vegetation			37.257654 °	37.262430 °
				-120.288501 °	-120.288346 °
DWR ID	DWR_NA0013_03_f_2024_8				
Comment Code					
V1 : Control annual grass and weeds on the levee slopes and easements.					
Inspector Comment

Looking downstream along the waterside slope. (Fall 2024)

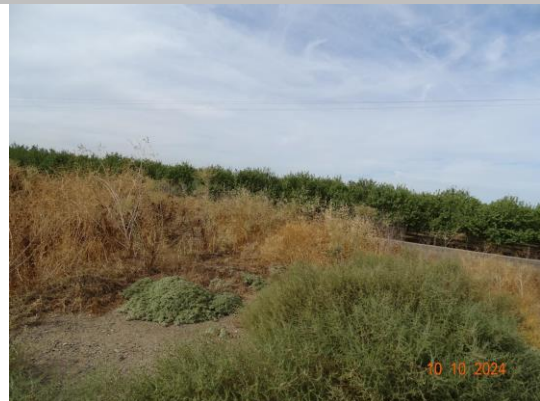
Photo 1 of 1 : FA_2024_NA0013_333_15_20241011_00025.jpg

LM Start	0.00	Rating **	U	Issue No.	15
LM End	0.34	Issue Type +	Ma	Location *	LS
Category	Earthen Levee			GPS Latitude/Longitude	
				Start	End
Item	Vegetation			37.257654 °	37.262431 °
				-120.288501 °	-120.288348 °
DWR ID	DWR_NA0013_03_f_2024_15				
Comment Code					
V1 : Control annual grass and weeds on the levee slopes and easements.					
Inspector Comment

View of landside slope looking downstream. (Fall 2024)

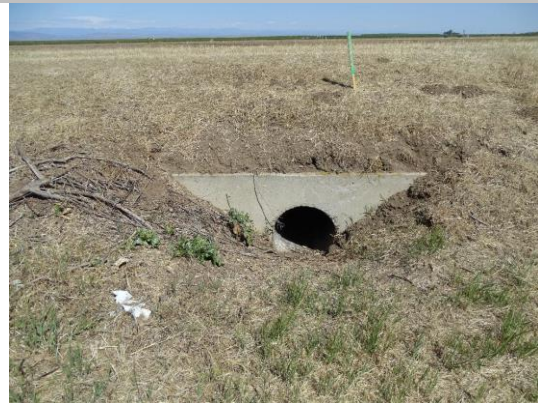
Photo 1 of 2 : UCIP_FA_2024_77927_111450.jpg

Comment Code						
Inspector Comment						
DS_ID:23060 FS_ID:77927 EP_NO: N/A Repair Type: No Action Needed EVAL Issue: Crossing Status: Found UCIP Comments: 12/20/2022 Record updated from Urgent to No Action Needed. Pipe has been CIPP lined. LOF of crossing is less or equal to 4. Recommend next video inspection in 5 years. (O.Yakimov - DWR UCIP) 04/13/2022 Record remains Urgent. DMP internal video inspection has found pipe integrity issues. LOF of crossing is between 5 and 6. Crossing will be monitored until funding becomes available to address the issues. Pipe inlet on LS has been cleared since last inspection as well as vegetation on LS and WS. (M.Thao - DWR UCIP) 09/17/2013 - more than a half of intet pipe burried on LS. needs vegetation cleaning on both sides.inlet needs silt removed and cleaning. (DWR UCIP - P. Amatya) FIELD_STRUCT_DESC: 24-inch CIPP-lined corrugated metal gravity drainage pipe through the levee, 6 feet below the crown. Concrete headwall, flap gate, and concrete grouted cobble spillway on the waterside (WS) toe. Concrete headwall on the landside (LS) toe. [Additional Reference(s): DWR Levee Log, 2005 (HLM 0.20). USACE San Joaquin O&M Manual 607, June 1962, (HLM 0.18), listed as 24-inch pipe]. FS Date: 4/13/2022 11:22:24 AM

LS view: Concrete headwall and pipe inlet at toe.

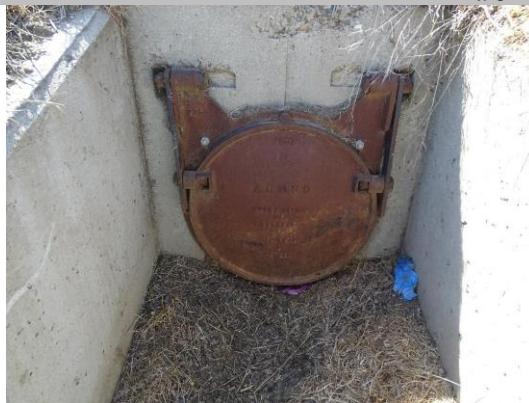
Photo 2 of 2 : UCIP_FA_2024_77927_111453.jpg

WS view: Close-up view of flap gate.

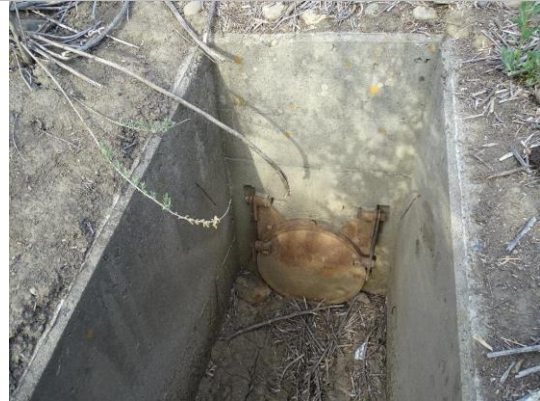
Photo 2 of 2 : UCIP_FA_2024_74601_111461.jpg

WS view: Close-up view of concrete headwall and flap gate.

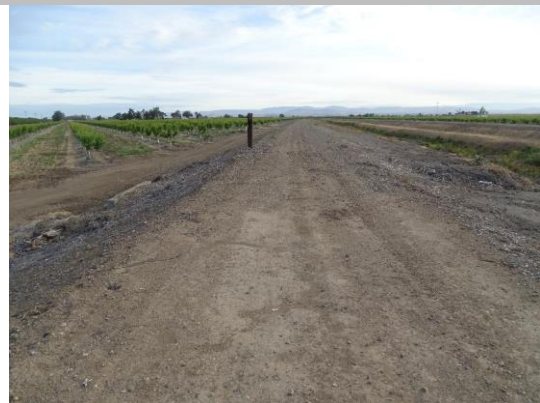
Photo 1 of 3 : UCIP_FA_2024_74603_111463.jpg

Levee crown looking upstream.

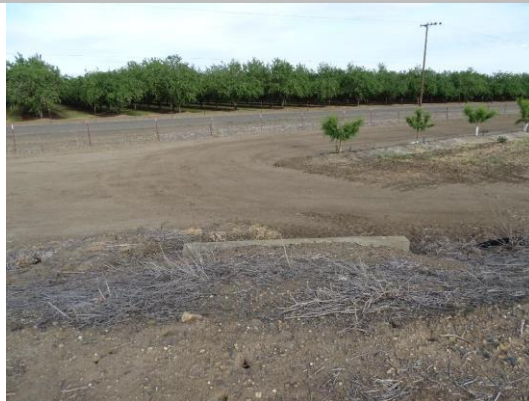
Photo 2 of 3 : UCIP_FA_2024_74603_111464.jpg

LS view: Looking from crown; backside of concrete headwall on toe.

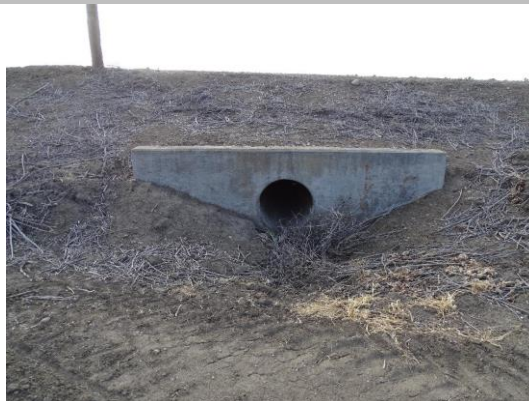
Photo 3 of 3 : UCIP_FA_2024_74603_111465.jpg

LS view: Concrete headwall and pipe inlet on toe.

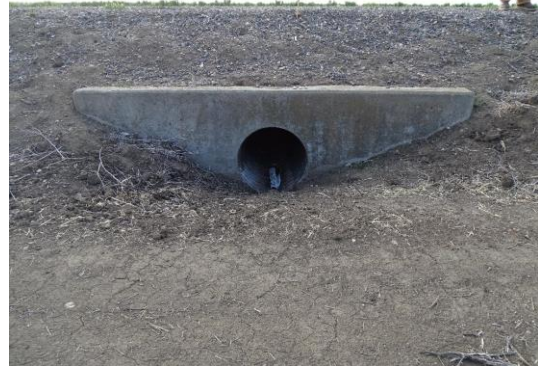
Photo 1 of 2 : UCIP_FA_2024_74604_111470.jpg

LS view: Concrete headwall and pipe inlet on toe.

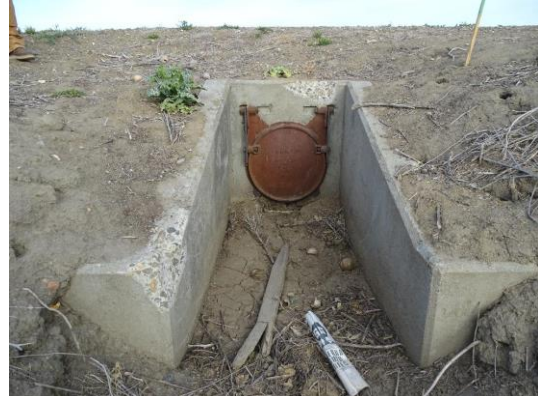
Photo 2 of 2 : UCIP_FA_2024_74604_111467.jpg

DS_ID:23063
FS_ID:74604
EP_NO: N/A
Repair Type: No Action Needed
EVAL Issue:
Crossing Status: Found
UCIP Comments: 09/18/2023 Record updated from Non-Urgent to No Action Needed. Pipe was CIPP lined. DMP internal video inspection has found none or minor pipe defects. Recommend next video inspection in 5 years. (O. Yakimov - DWR UCIP)
04/14/2022 Record updated from No Action Needed to Non-Urgent. DMP internal video inspection has found pipe integrity issues. LOF of crossing is greater than or equal to 4.1 and less than 5. Crossing will be monitored until funding becomes available for rehabilitation. (M.Thao - DWR UCIP)
09/2016: LS and WS ends have been cleared by NA0013 and crossing has been downgraded to No Action Needed. (K. Fazel - UCIP)
09/2013: Needs vegetation clearing on WS. (P. Amatya - UCIP)
FIELD_STRUCT_DESC: 24-inch CIPP-lined corrugated metal gravity drainage pipe through the levee, 6.5 feet below the crown. Concrete headwall, flap gate, and concrete grouted cobble spillway on the waterside (WS) toe. Concrete headwall on the landside (LS) toe.

WS view: Concrete headwall, spillway, and flap gate on toe.

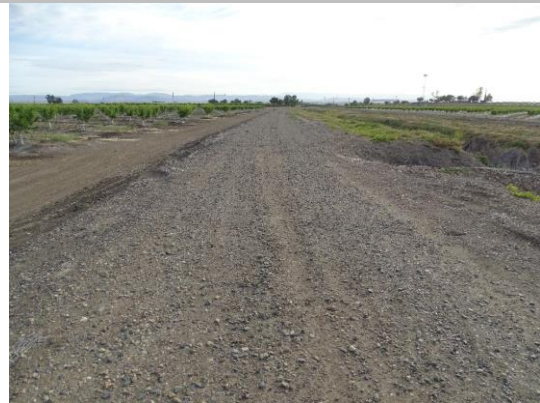
Photo 1 of 3 : UCIP_FA_2024_74606_111473.jpg

Comment Code					
Inspector Comment					
DS_ID:23064 FS_ID:74606 EP_NO: N/A Repair Type: No Action Needed EVAL Issue: Crossing Status: Found UCIP Comments: 04/14/2022 Record updated from Non-Urgent to No Action Needed. DMP internal video inspection has not found pipe integrity issues. LOF of crossing is less or equal to 4. Recommend next video inspection in 5 years. No issues observed during inspection. (M.Thao - DWR UCIP) 09/29/2016: WS outlet has been cleared by NA0013. Crossing will be downgraded from Non-Urgent to No Action Needed upon receipt of photo showing cleared LS. (K. Fazel - UCIP) 09/2013: vegetations need to be removed from spillway and outlet at flapgate (blocked). It needs clearing more than half of inlet pipe was buried in inlet. It needs cleaning & clearing. (P. Amatya - UCIP) FIELD_STRUCT_DESC: 24-inch corrugated metal gravity drainage pipe through the levee, 5 feet below the crown. Concrete headwall, flap gate, and concrete grouted cobble spillway on the waterside (WS) toe. Concrete headwall on the landside (LS) toe. [Additional Reference(s): DWR Levee Log, 2005 (HLM 1.04). USACE San Joaquin O&M Manual 607, June 1962, (HLM 1.04), listed as 24-inch pipe]. FS Date: 4/14/2022

Levee crown looking upstream.

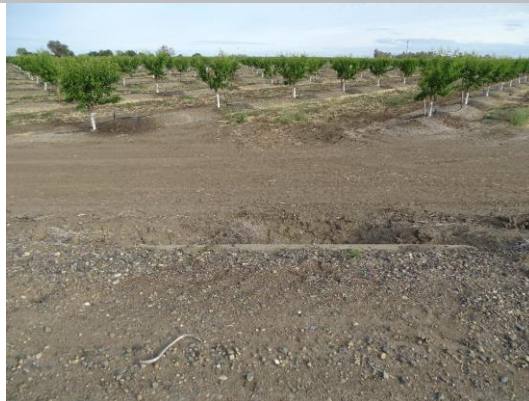
Photo 2 of 3 : UCIP_FA_2024_74606_111474.jpg

LS view: Looking from crown; general overview.

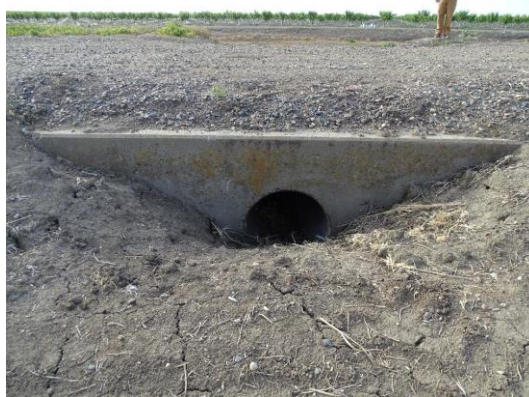
Photo 3 of 3 : UCIP_FA_2024_74606_111475.jpg

LS view: Concrete headwall and pipe inlet on toe.

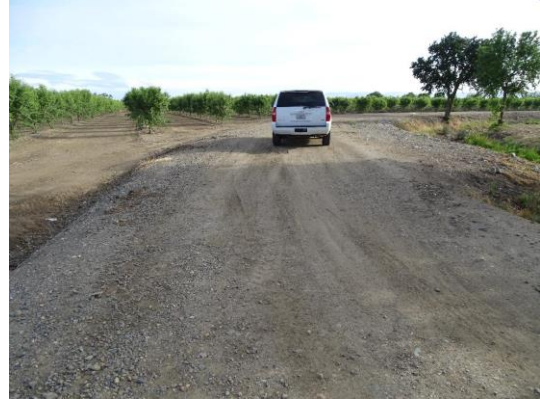
Photo 1 of 3 : UCIP_FA_2024_74610_111482.jpg

Comment Code					
Inspector Comment					
DS_ID:23066 FS_ID:74610 EP_NO: N/A Repair Type: No Action Needed EVAL Issue: Crossing Status: Found UCIP Comments: 04/14/2022 Record updated from Non-Urgent to No Action Needed. DMP internal video inspection has not found pipe integrity issues. LOF of crossing is less or equal to 4. Recommend next video inspection in 5 years. Cleaning and clearing of vegetation and silt deposited inside the pipe was previously addressed and no issues observed during inspection. (M.Thao - DWR UCIP) 09/17/2013 - needs clearing and cleaning of vegetations on both ends of the pipe.needs clearing and cleaning of silt deposited inside of the pipe. (DWR UCIP - P. Amatya) FIELD_STRUCT_DESC: 24-inch corrugated metal gravity drainage pipe through the levee, 4 feet below the crown. Concrete headwall, flap gate, and concrete grouted cobble spillway on the waterside (WS) toe. Concrete headwall on the landside (LS) toe. [Additional Reference(s): DWR Levee Log, 2005 (HLM 1.28). USACE San Joaquin O&M Manual 607, June 1962, (HLM 1.29), listed as 24-inch pipe]. FS Date: 4/14/2022

Levee crown looking upstream.

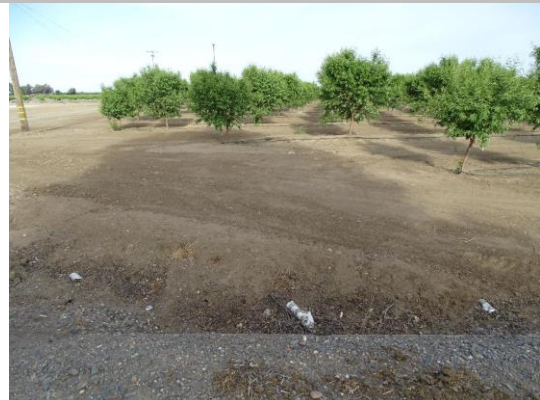
Photo 2 of 3 : UCIP_FA_2024_74610_111483.jpg

LS view: Looking from crown; general overview.

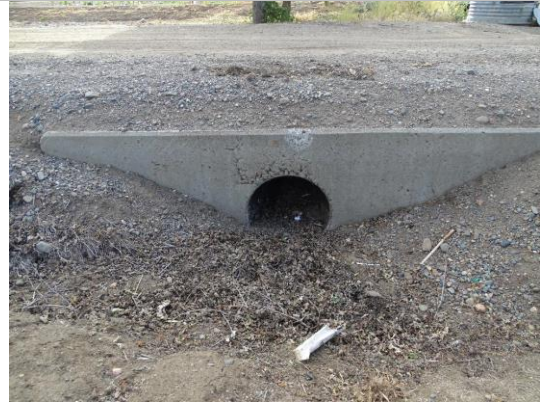
Photo 3 of 3 : UCIP_FA_2024_74610_111484.jpg

LS view: Concrete headwall and pipe inlet on toe.

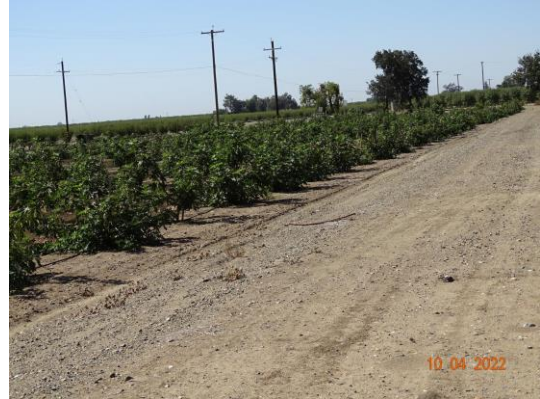
Photo 1 of 1 : FA_2024_NA0013_334_16_20240828_00006.jpg

LM Start	0.01	Rating **	M	Issue No.	16
LM End	0.12	Issue Type +	En	Location *	LS
Category	Earthen Levee			GPS Latitude/Longitude	
				Start	End
Item	Encroachments			37.273345 °	37.273215 °
				-120.277834 °	-120.279865 °
DWR ID	DWR_NA0013_04_f_2022_16				
Comment Code					
CR : Crops					
Inspector Comment					
Crops planted approximately 5 ft from landside toe should be move outside the 20 ft easement.

Crops planted within the easement of the landside toe. (Fall 2022)

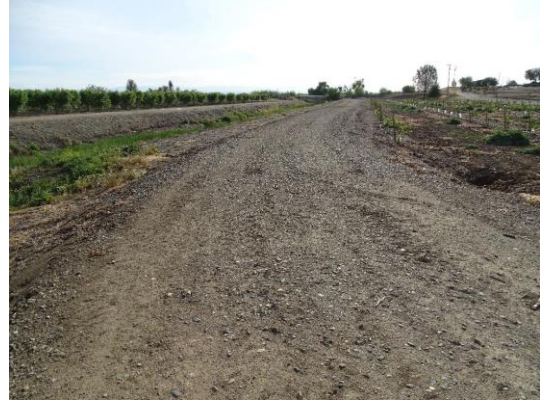
Photo 1 of 3 : UCIP_FA_2024_77414_111520.jpg

Comment Code						
Inspector Comment						
DS_ID:23068 FS_ID:77414 EP_NO: N/A Repair Type: Non-Urgent EVAL Issue: 11, Maintenance Compliance Issue Crossing Status: Found UCIP Comments: 04/14/2022 Record remains Non-Urgent. Flap gate blocked by debris on WS; recommend removing debris. Vegetation has been cleared on LS. DMP internal video inspection has not found pipe integrity issues. LOF of crossing is less or equal to 4. Recommend next video inspection in 5 years. (M.Thao - DWR UCIP) 09/17/2013 - needs vegetation clearing on both sides. Flapgate blocked by debris on WS. inlet and outlet need silt clearing and cleaning. (DWR UCIP - P. Amatya) FIELD_STRUCT_DESC: 24-inch corrugated metal gravity drainage pipe through the levee, 5 feet below the crown. Concrete headwall, flap gate, and concrete grouted cobble spillway on the waterside (WS) toe. Concrete headwall on the landside (LS) toe. [Additional Reference(s): DWR Levee Log, 2005 (HLM 0.10). USACE San Joaquin O&M Manual 607, June 1962, (HLM 0.10), listed as 24-inch pipe]. FS Date: 4/14/2022

Levee crown looking downstream.

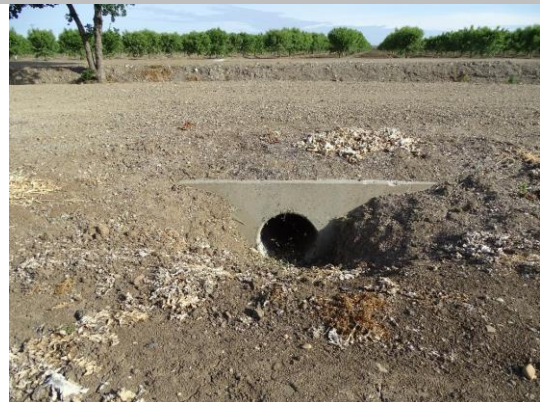
Photo 2 of 3 : UCIP_FA_2024_77414_111521.jpg

LS view: Concrete headwall and pipe inlet on toe.

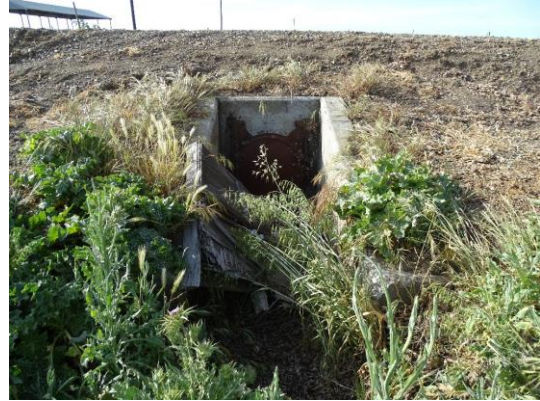
Photo 3 of 3 : UCIP_FA_2024_77414_111522.jpg

WS view: Concrete headwall, spillway, and flap gate on toe.

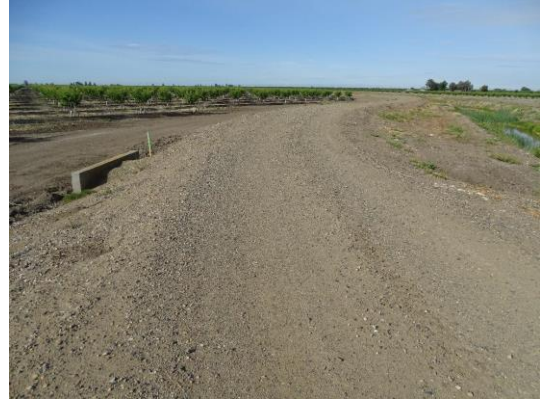
Photo 1 of 3 : UCIP_FA_2024_74658_111523.jpg

Comment Code						
Inspector Comment						
DS_ID:23069 FS_ID:74658 EP_NO: N/A Repair Type: Non-Urgent EVAL Issue: 10, Unauthorized Modification or Non-Compliant Permit Crossing Status: Found UCIP Comments: 09/18/2023 Pipe was CIPP lined. DMP internal video inspection has found none or minor pipe defects. Recommend next video inspection in 5 years. (O. Yakimov - DWR UCIP) 04/14/2022 Record remains Non-Urgent. DMP internal video inspection has found pipe integrity issues. LOF of crossing is greater than or equal to 4.1 and less than 5. Crossing will be monitored until funding becomes available for rehabilitation. A PVC pipe was placed into the CMP drainage pipe for unknown reasons; unable to find a permit for modification. (M.Thao - DWR UCIP) 09/29/2016: WS and LS ends have been cleared. Crossing will be downgraded from Non-Urgent to No Action Needed upon receipt of photo showing cleared LS inlet. (K. Fazel - UCIP) 09/20/2013 needs vegetation clearing on both sides. Flapgate blocked on WS: inlet pipe needs clearing on landside. (P. Amatya - UCIP) FIELD_STRUCT_DESC: 24-inch CIPP-lined corrugated metal gravity drainage pipe through the levee, 6 feet below the crown. Concrete headwall, flap gate, and concrete grouted cobble spillway on the waterside (WS) toe. Concrete headwall on the landside (LS) toe. [Additional Reference(s): DWR Levee Log, 2005 (HLM 0.17). USACE San Joaquin O&M Manual 607, June 1962, (HLM 0.17), listed as 24-inch pipe]. FS Date: 4/14/2022

Levee crown looking downstream.

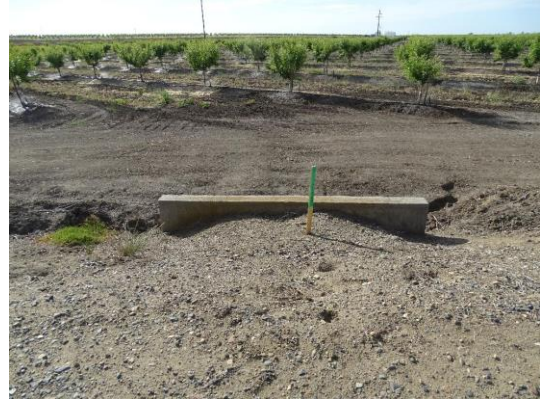
Photo 2 of 3 : UCIP_FA_2024_74658_111524.jpg

LS view: Looking from crown; backside of concrete headwall on toe.

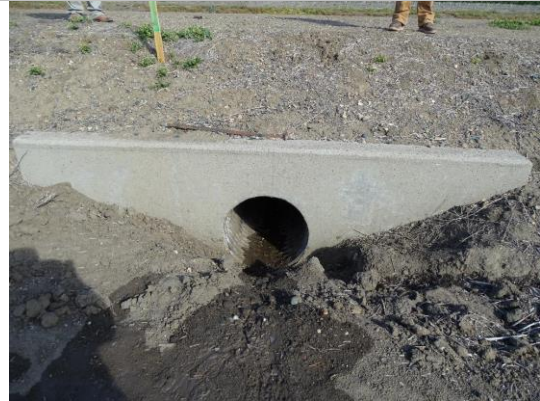
Photo 1 of 2 : UCIP_FA_2024_74630_111540.jpg

Comment Code						
Inspector Comment						
DS_ID:23070 FS_ID:74630 EP_NO: N/A Repair Type: No Action Needed EVAL Issue: Crossing Status: Found UCIP Comments: 09/18/2023 Record updated from Non-Urgent to No Action Needed. Pipe was CIPP lined. DMP internal video inspection has found none or minor pipe defects. Recommend next video inspection in 5 years. (O. Yakimov - DWR UCIP) 04/14/2022 Record remains Non-Urgent. DMP internal video inspection has found pipe integrity issues. LOF of crossing is greater than or equal to 4.1 and less than 5. Crossing will be monitored until funding becomes available for rehabilitation. Pipe on LS and WS have been cleared, but sediment buildup is present on spillway on WS. The sediment buildup does not currently impact operation of flap gate. (M.Thao - DWR UCIP) 09/29/2016: WS and LS ends have been cleared by Mike Walejko of NA0013. Crossing will be downgraded from Non-Urgent to No Action Needed upon receipt of photo showing cleared LS inlet. (K. Fazel - UCIP) 09/20/2013needs vegetation clearing on watersideinlet on landside needs clearing. (P. Amatya - UCIP) FIELD_STRUCT_DESC: 24-inch CIPP-lined corrugated metal gravity drainage pipe through the levee, 6 feet below the crown. Concrete headwall, flap gate, and concrete grouted cobble spillway on the waterside (WS) toe. Concrete headwall on the landside (LS) toe. [Additional Reference(s): DWR Levee Log, 2005 (HLM 0.31) . USACE San Joaquin O&M Manual 607, June 1962, (HLM 0.31), listed as 24-inch pipe]. FS Date: 4/14/2022

LS view: Concrete headwall and pipe inlet on toe.

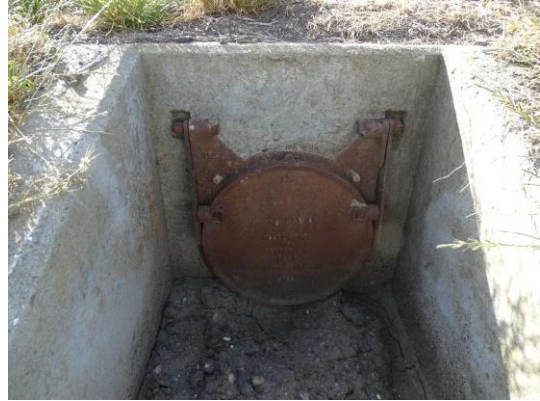
Photo 2 of 2 : UCIP_FA_2024_74630_111537.jpg

WS view: Close-up view on flap gate not impacted by sediment buildup.

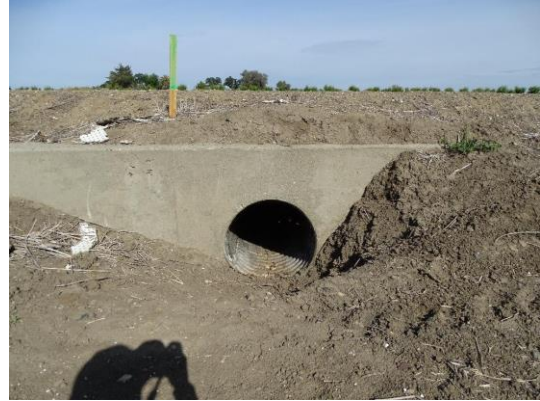
Photo 1 of 2 : UCIP_FA_2024_74632_111547.jpg

DS_ID:23071
FS_ID:74632
EP_NO: N/A
Repair Type: No Action Needed
EVAL Issue:
Crossing Status: Found
UCIP Comments: 09/18/2023 Record updated from Non-Urgent to No Action Needed. Pipe was CIPP lined. DMP internal video inspection has found none or minor pipe defects. Recommend next video inspection in 5 years. (O. Yakimov - DWR UCIP)
04/14/2022 Record updated from No Action Needed to Non-Urgent. DMP internal video inspection has found pipe integrity issues. LOF of crossing is greater than or equal to 4.1 and less than 5. Crossing will be monitored until funding becomes available for rehabilitation. (M.Thao - DWR UCIP)
09/29/2016: WS headwall, flap gate and spillway have been cleared of vegetation by Mike Walejko of NA0013. Crossing has been downgraded from Non-Urgent to No Action Needed. (K. Fazel - UCIP)
09/2013: vegetations clearing on spillway area. (P. Amatya - UCIP)
FIELD_STRUCT_DESC: 24-inch CIPP-lined corrugated metal gravity drainage pipe through the levee, 5 feet below the crown. Concrete headwall, flap gate, and concrete grouted cobble spillway on the waterside (WS) toe. Concrete headwall on the landside (LS) toe.

LS view: Concrete headwall and pipe inlet on toe.

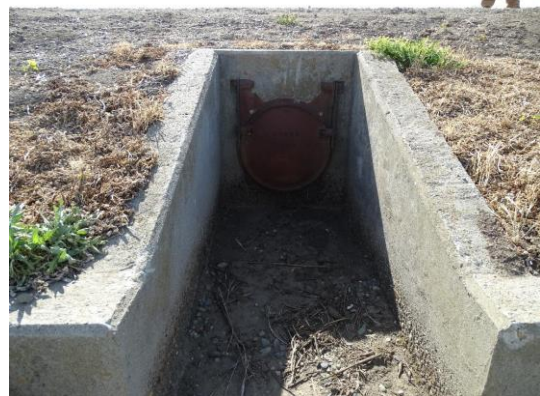
Photo 2 of 2 : UCIP_FA_2024_74632_111548.jpg

WS view: Concrete headwall, spillway, and flap gate on toe.

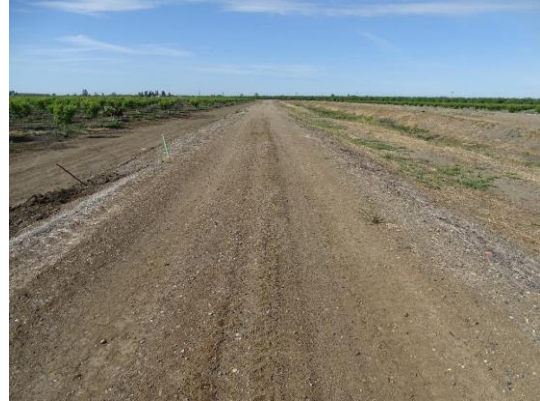
Photo 1 of 3 : UCIP_FA_2024_74659_111555.jpg

Comment Code						
Inspector Comment						
DS_ID:23072 FS_ID:74659 EP_NO: N/A Repair Type: No Action Needed EVAL Issue: Crossing Status: Found UCIP Comments: 09/18/2023 Record updated from Non-Urgent to No Action Needed. Pipe was CIPP lined. DMP internal video inspection has found none or minor pipe defects. Recommend next video inspection in 5 years. (O. Yakimov - DWR UCIP) 04/14/2022 Record remains Non-Urgent. DMP internal video inspection has found pipe integrity issues. LOF of crossing is greater than or equal to 4.1 and less than 5. Crossing will be monitored until funding becomes available for rehabilitation. The headwall and pipe inlet was not found on LS toe. Need to coordinate with LMA to determine status of crossing. (M.Thao - DWR UCIP) 09/29/2016: WS cleared by NA0013. Crossing will be downgraded from Non-Urgent to No Action Needed upon receipt of photo showing cleared LS inlet. (K. Fazel - UCIP) 09/2013needs vegetation clearing on both levee sides. (P. Amatya - UCIP) FIELD_STRUCT_DESC: 24-inch CIPP-lined corrugated metal gravity drainage pipe through the levee, 6 feet below the crown. Concrete headwall, flap gate, and concrete grouted cobble spillway on the waterside (WS) toe. Concrete headwall on the landside (LS) toe. [Additional Reference(s): DWR Levee Log, 2005 (HLM 0.58). USACE San Joaquin O&M Manual 607, June 1962, (HLM 0.58), listed as 24-inch pipe]. FS Date: 4/14/2022

Levee crown looking downstream.

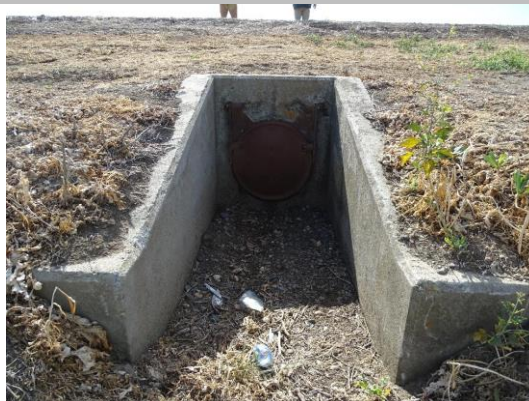
Photo 3 of 3 : UCIP_FA_2024_74659_111558.jpg

WS view: Concrete headwall, spillway, and flap gate on toe.

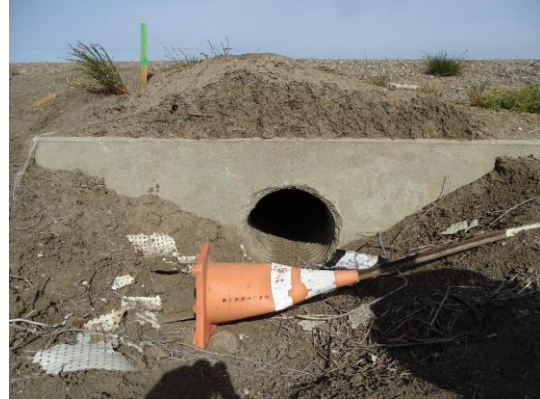
Photo 1 of 3 : UCIP_FA_2024_74660_111561.jpg

DS_ID:23073
FS_ID:74660
EP_NO: N/A
Repair Type: Urgent
EVAL Issue: 2b, Levee Integrity
Crossing Status: Found
UCIP Comments: 12/20/2022 Record remains Urgent. Pipe has been CIPP-lined. LOF of crossing is less or equal to 4. Recommend next video inspection in 5 years. Erosion around concrete headwall on WS toe needs to be addressed. (O.Yakimov - DWR UCIP)
04/14/2022 Record updated from Non-Urgent to Urgent. Levee disturbance caused by erosion is greater than 1/2 foot in depth around concrete headwall on WS toe. DMP internal video inspection has found pipe integrity issues. LOF of crossing is greater than or equal to 4.1 and less than 5. Crossing will be monitored until funding becomes available for rehabilitation. (M.Thao - DWR UCIP)
09/17/2013 - needs vegetation clearing on waterside concrete spillway on waterside the drainage was working during field survey. (DWR UCIP - P. Amatya)
FIELD_STRUCT_DESC: 24-inch CIPP-lined corrugated metal gravity drainage pipe through the levee, 6 feet below the crown. Concrete headwall, flap gate, and concrete grouted cobble spillway on the waterside (WS) toe. Concrete headwall on the landside (LS) toe.

LS view: Concrete headwall and pipe inlet on toe.

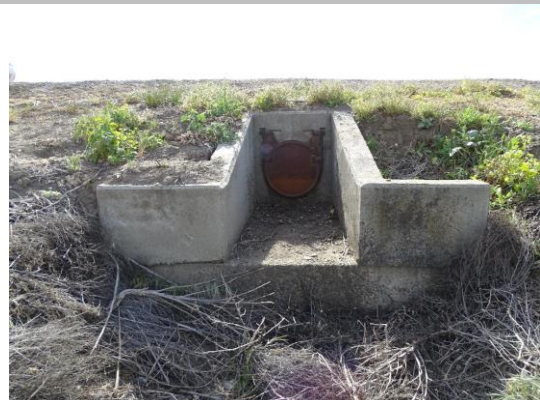
Photo 2 of 3 : UCIP_FA_2024_74660_111562.jpg

WS view: Concrete headwall, spillway, and flap gate on toe.

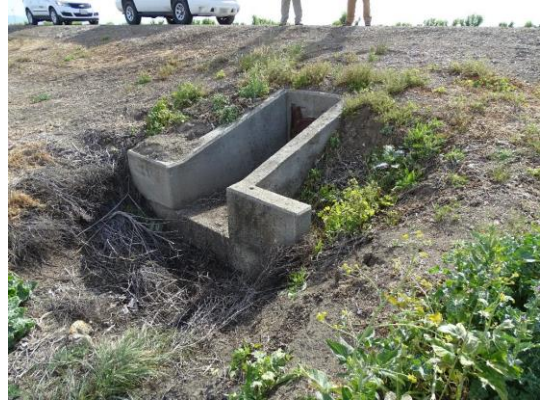
Photo 3 of 3 : UCIP_FA_2024_74660_111563.jpg

WS view: Erosion present around concrete headwall.

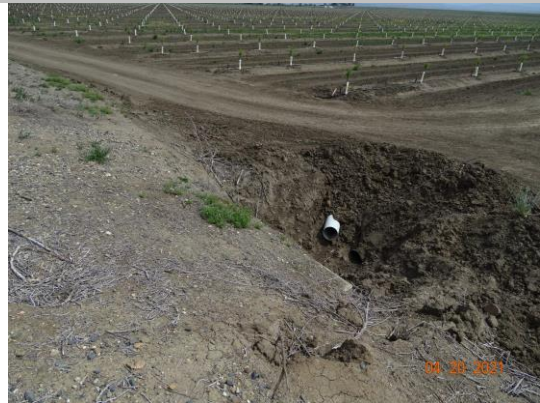
Photo 1 of 1 : FA_2024_NA0013_334_13_20240828_00003.jpg

LM Start	1.01	Rating **	M	Issue No.	13
LM End	1.01	Issue Type +	En	Location *	LS
Category	Earthen Levee			GPS Latitude/Longitude	
				Start	End
Item	Encroachments			37.263139 °	37.263139 °
				-120.287799 °	-120.287799 °
DWR ID	DWR_NA0013_04_s_2021_13				
Comment Code					
PI : Pipe					
Inspector Comment					
There appears to be installed drainage pipes feeding the existing pipe crossing. There is no known permit related to these pipes.

Drainage pipes feeding to existing pipe crossing. (Spring 2021)

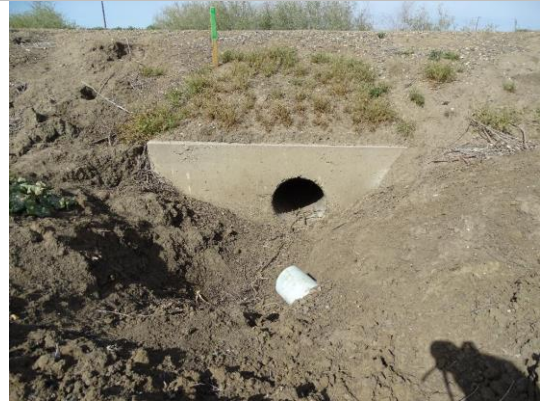
Photo 1 of 2 : UCIP_FA_2024_74642_111566.jpg

DS_ID:23074
FS_ID:74642
EP_NO: N/A
Repair Type: No Action Needed
EVAL Issue:
Crossing Status: Found
UCIP Comments: 09/18/2023 Record updated from Non-Urgent to No Action Needed. Pipe was CIPP lined. DMP internal video inspection has found none or minor pipe defects. Recommend next video inspection in 5 years. (O. Yakimov - DWR UCIP)
04/14/2022 Record updated from No Action Needed to Non-Urgent. DMP internal video inspection has found pipe integrity issues. LOF of crossing is greater than or equal to 4.1 and less than 5. Crossing will be monitored until funding becomes available for rehabilitation. Appears two PVC pipes have been placed landward off levee toe and covered with fill; no modifications to crossing observed. The PVC pipes now drain to the crossing. (M.Thao - DWR UCIP)
09/17/2013 - concrete spillway on waterside.drainage was working during field survey (DWR UCIP - P. Amaty).
FIELD_STRUCT_DESC: 24-inch CIPP-lined corrugated metal gravity drainage pipe through the levee, 8 feet below the crown. Concrete headwall, flap gate, and concrete grouted cobble spillway on the waterside (WS) toe. Concrete headwall on the landside (LS) toe.

LS view: Concrete headwall and pipe inlet on toe.

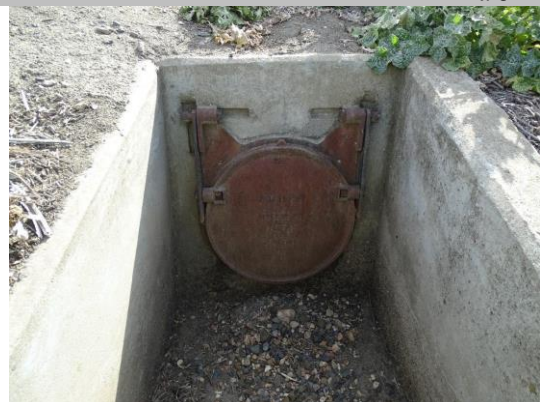
Photo 2 of 2 : UCIP_FA_2024_74642_111568.jpg

WS view: Concrete headwall, spillway, and flap gate on toe.

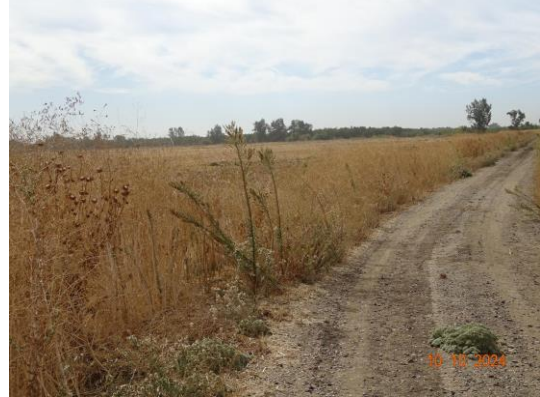
Photo 1 of 1 : FA_2024_NA0013_334_17_20241011_00030.jpg

LM Start	1.07	Rating **	M	Issue No.	17
LM End	1.40	Issue Type +	Ma	Location *	LS
Category	Earthen Levee			GPS Latitude/Longitude	
				Start	End
Item	Vegetation			37.262258 °	37.257620 °
				-120.288163 °	-120.288078 °
DWR ID	DWR_NA0013_04_f_2024_17				
Comment Code					
V1 : Control annual grass and weeds on the levee slopes and easements.					
Inspector Comment

View of vegetation on the landside slope. (Fall 2024)

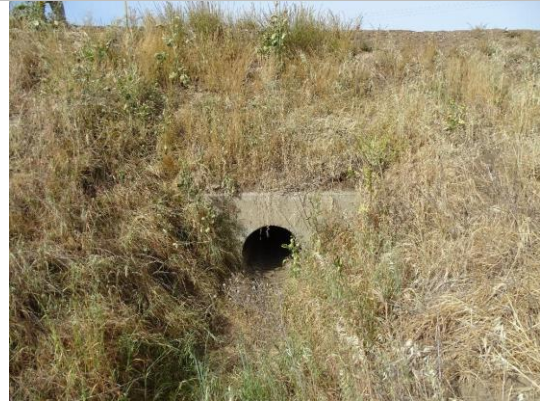
Photo 1 of 2 : UCIP_FA_2024_74643_111570.jpg

Comment Code						
Inspector Comment						
DS_ID:23075 FS_ID:74643 EP_NO: N/A Repair Type: No Action Needed EVAL Issue: Crossing Status: Found UCIP Comments: 09/18/2023 Record updated from Non-Urgent to No Action Needed. Pipe was CIPP lined. DMP internal video inspection has found none or minor pipe defects. Recommend next video inspection in 5 years. (O. Yakimov - DWR UCIP) 04/14/2022 Record remains Non-Urgent. DMP internal video inspection has found pipe integrity issues. LOF of crossing is greater than or equal to 4.1 and less than 5. Crossing will be monitored until funding becomes available for rehabilitation. No issues observed during inspection. (M.Thao - DWR UCIP) 09/17/2013 - needs clearing on both inlet and outlet. needs vegetations clearing on spillway on waterside and inlet on landside. (DWR UCIP - P. Amatya) FIELD_STRUCT_DESC: 24-inch CIPP-lined corrugated metal gravity drainage pipe through the levee, 10 feet below the crown. Concrete headwall, flap gate, and concrete grouted cobble spillway on the waterside (WS) toe. Concrete headwall on the landside (LS) toe. [Additional Reference(s): DWR Levee Log, 2005 (HLM 1.08). USACE San Joaquin O&M Manual 607, June 1962, (HLM 1.08), listed as 24-inch pipe]. FS Date: 4/14/2022

LS view: Concrete headwall and pipe inlet on toe.

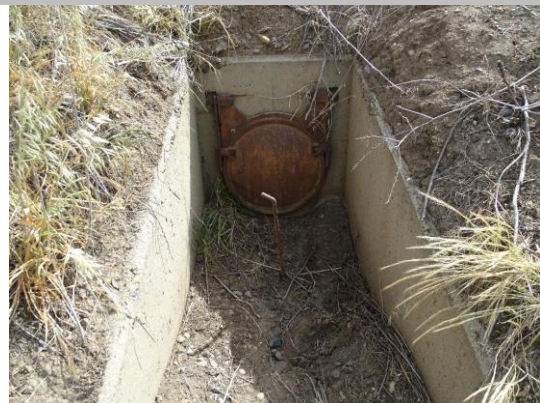
Photo 2 of 2 : UCIP_FA_2024_74643_111572.jpg

WS view: Concrete headwall, spillway, and flap gate on toe.

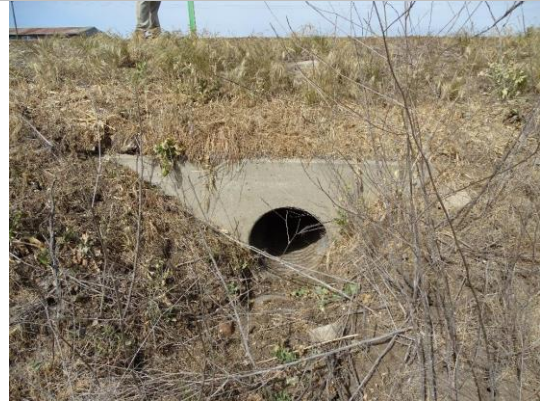
Photo 1 of 2 : UCIP_FA_2024_74650_111587.jpg

DS_ID:23076
FS_ID:74650
EP_NO: N/A
Repair Type: No Action Needed
EVAL Issue:
Crossing Status: Found
UCIP Comments: 09/18/2023 Record updated from Non-Urgent to No Action Needed. Pipe was CIPP lined. DMP internal video inspection has found none or minor pipe defects. Recommend next video inspection in 5 years. (O. Yakimov - DWR UCIP)
04/14/2022 Record updated from No Action Needed to Non-Urgent. DMP internal video inspection has found pipe integrity issues. LOF of crossing is greater than or equal to 4.1 and less than 5. Crossing will be monitored until funding becomes available for rehabilitation. No issues observed during inspection. (M.Thao - DWR UCIP)
09/01/2016: Per Mike Walejko, WS outlet has been cleared. See photos. Crossing has been downgraded from Urgent to No Action Needed. (K. Fazel - UCIP)
08/23/2016: LS inlet is clear. WS outlet is still buried. Cracks on crown characteristic of entire left bank and not associated with the crossing at this location. (K. Fazel - UCIP)

09/17/2013: significant levee crown and slope cracks along the pipe. Detailed investigation required. inlet pipe buried on landside. Needs removal of silts. Needs clearing and cleaning half of outlet pipe buried. Needs clearing and removal of vegetations and silts. (P. Amatya - UCIP)
FIELD_STRUCT_DESC: 24-inch CIPP-lined corrugated metal gravity drainage pipe through the levee, 10 feet below the crown. Concrete headwall, flap gate, and concrete grouted cobble spillway on the waterside (WS) toe. Concrete headwall on the landside (LS) toe.
[Additional Reference(s): DWR Levee Log, 2005 (HLM 1.24). USACE San Joaquin O&M Manual 607, June 1962, (HLM 1.24), listed as 24-inch pipe].
FS Date: 4/14/2022

LS view: Concrete headwall and pipe inlet at toe.

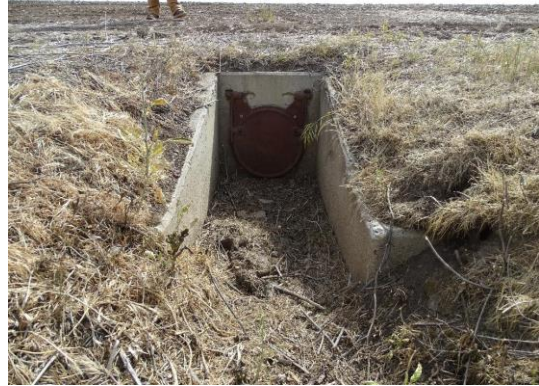
Photo 2 of 2 : UCIP_FA_2024_74650_111588.jpg

WS view: Concrete headwall, spillway, and flap gate on toe.
