**Flood Control Project Maintenance
Levee Inspections**

Maintenance Issue Types Only, Levee Inspection Report By Mile - Fall 2017

San Joaquin County Flood Control and Water Conservation District

Waterway	Bank	Unit Miles	Inspection Start/End	Inspector
Unit No. 01 Littlejohn Creek	Left	2.59	10/17/2017 10/17/2017	Pavel Kazi

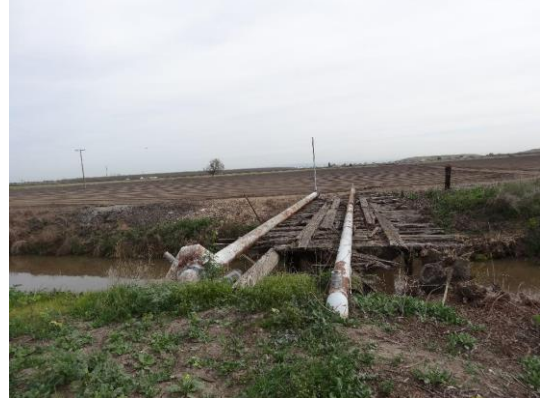
Photo 1 of 3 : UCIP_FA_2017_32744_59245.jpg

Comment Code					
Inspector Comment					
FS_ID:32744 DS_ID:23992 EP_NO: N/A Repair Type: No Action Needed Crossing Status: Found UCIP Comments: One 4-inch pvc pipe on the waterside levee slope. It is not clear whether the pvc pipe goes through the levee. One air vent on waterside and another across the channel. Water filter plant on landside. Not found : 24-inch CMP through levee and with flap gate. On landside a vertical pump on wooden structure; walkway to the pump; service pole and switch box. Pump is connected to 8-inch steel pipe for about 100 ft. 24-inch CMP continues through the levee. FIELD_STRUCT_DESC: 8-inch steel storm drainage pipe through the levee, 2 feet below the crown. Pipe goes over the top of the channel on a wood structure. One air vent on the waterside (WS) and another across the channel. Water filter plant on the landside (LS). [Additional Reference(s): DWR Levee Log, 1977, listed as a 14-inch pipe. USACE San Joaquin O&M Manual 613C, Volume 15, May 1963, (Station 131+25 "'S'"), listed as a 24-inch corrugated metal pipe (CMP) with a flap gate]. FS Date: 3/25/2014

WS view: two steel pipes through the levee and over Little John's Creek on wooden structure.

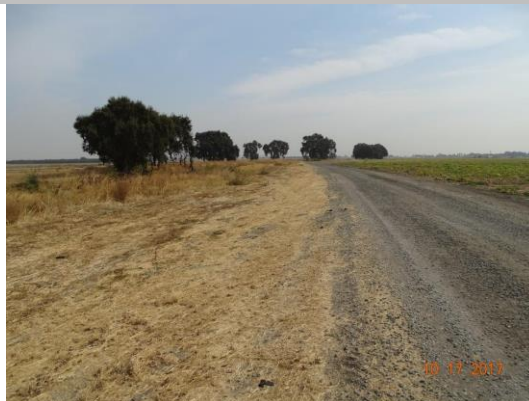
Photo 1 of 1 : FA_2017_NA0017_148_16_20171023_00055.jpg

LM Start	0.55	Rating **	A	Issue No.	16
LM End	0.55	Issue Type +	Ma	Location *	WS
Category	Earthen Levee			GPS Latitude/Longitude	
				Start	End
Item	Vegetation			37.876966 °	37.876966 °
				-121.238734 °	-121.238734 °
DWR ID	DWR_NA0017_01_f_2017_16				
Comment Code					
V1 : Control annual grass and weeds on the levee slopes and easements.					
Inspector Comment					
Acceptable vegetation.

View of the waterside slope of the levee looking upstream. Fall 2017

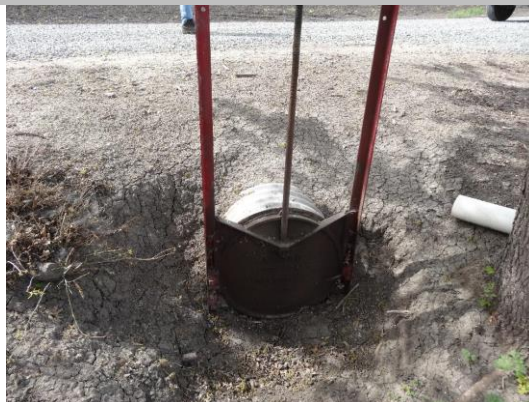
Photo 1 of 3 : UCIP_FA_2017_32745_59248.jpg

LM Start	0.74	Rating **	A/W	Issue No.	200
LM End	0.74	Issue Type +	Ma	Location *	
Category	Supplemental			GPS Latitude/Longitude	
				Start	End
Item	DWR UCIP LMA Responsibility			37.878634 °	37.878634 °
				-121.241467 °	-121.241467 °
DWR ID					
Comment Code					
Inspector Comment					
FS_ID:32745					
DS_ID:17973					
EP_NO: N/A					
Repair Type: No Action Needed					
Crossing Status: Found					
UCIP Comments: May need cleaning of mud in inlet pipe.					
FIELD_STRUCT_DESC: 24-inch corrugated metal drainage pipe through the levee, 4.2 feet below the crown. Slide gate on the waterside (WS) end. [Additional Reference(s): DWR Levee Log, 1977. USACE San Joaquin O&M Manual 613C, Volume 15, May 1963, (Station 98+65)].					
FS Date: 3/25/2014

WS view: CMP with slide gate on levee slope.

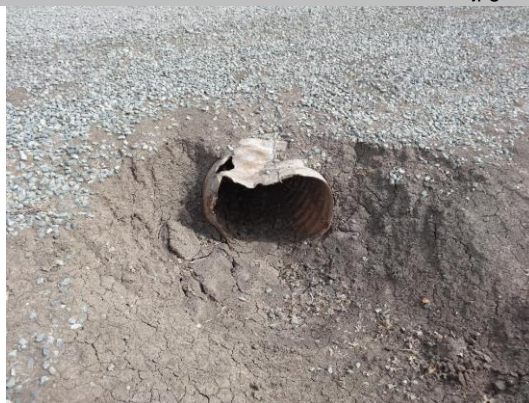
Photo 2 of 3 : UCIP_FA_2017_32745_59247.jpg

LS view: deformed inlet CM pipe on drainage ditch.

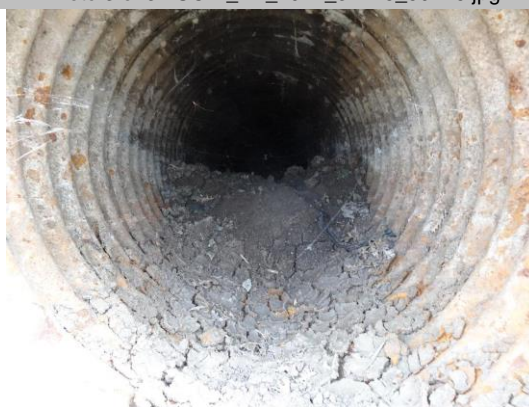
Photo 3 of 3 : UCIP_FA_2017_32745_59246.jpg

LS view: inside view of the CM pipe. May need cleaning and clearing the pipe.

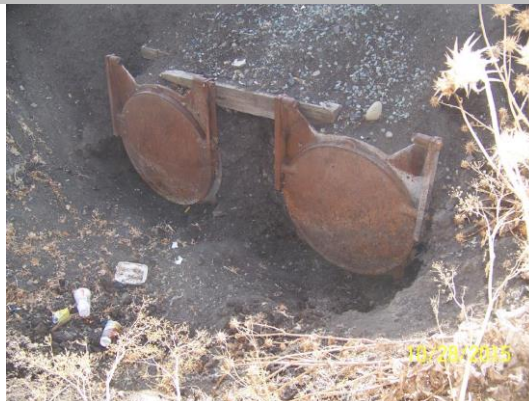
Photo 1 of 3 : UCIP_FA_2017_46809_74752.jpg

LM Start	0.79	Rating **	M	Issue No.	202
LM End	0.79	Issue Type +	Ma	Location *	
Category	Supplemental			GPS Latitude/Longitude	
				Start	End
Item	DWR UCIP LMA Responsibility			37.878502 °	37.878502 °
				-121.242377 °	-121.242377 °
DWR ID					
Comment Code					
Inspector Comment					
FS_ID:46809					
DS_ID:17972					
EP_NO: N/A					
Repair Type: Non-Urgent					
Crossing Status: Found					
UCIP Comments: LS: vegetation debris and mud on inlet ditch and inside the pipe.					
FIELD_STRUCT_DESC: 1 of 2: 36-inch corrugated metal drainage pipe through the levee, 6.6 feet below the crown. Flap gate on the waterside (WS) end. [Additional Reference(s): DWR Levee Log, 1977. USACE San Joaquin O&M Manual 613C, Volume 15, May 1963 (Station 94+40)].					
FS Date: 3/25/2014

WS: Debris blocking flap gate has been cleared per FPIIB Inspector email 11/16/2015

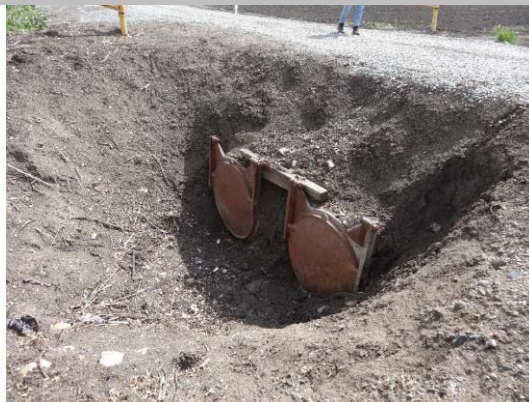
Photo 2 of 3 : UCIP_FA_2017_46809_59185.jpg

WS view: CMP drain pipes with flap gates on ditch.

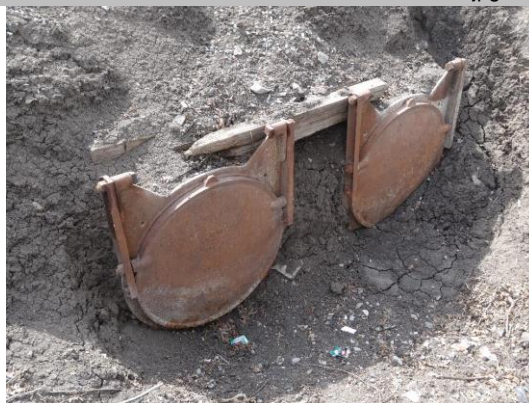
Photo 2 of 3 : UCIP_FA_2017_32704_59190.jpg

LM Start	0.79	Rating **	M	Issue No.	203 (cont)	
LM End	0.79	Issue Type +	Ma	Location *		
Category	Supplemental			GPS Latitude/Longitude		
				Start	End	
Item	DWR UCIP LMA Responsibility			37.878494 °	37.878494 °	
				-121.242392 °	-121.242392 °	
DWR ID						
Comment Code						
Inspector Comment						
FS_ID:32704						
DS_ID:23995						
EP_NO: N/A						
Repair Type: Non-Urgent						
Crossing Status: Found						
UCIP Comments: Needs cleaning and clearing the culvert.						
FIELD_STRUCT_DESC: 2 of 2: 36-inch corrugated metal drainage pipe through the levee, 6.6 feet below the crown. Flap gate on the waterside (WS) end. [Additional Reference(s): DWR Levee Log, 1977. USACE San Joaquin O&M Manual 613C, Volume 15, May 1963 (Station 94+40)].						
FS Date: 3/25/2014

WS view: closer view of CMP drain pipes with flap gates on ditch. Right flap gate was blocked by soil/mud.

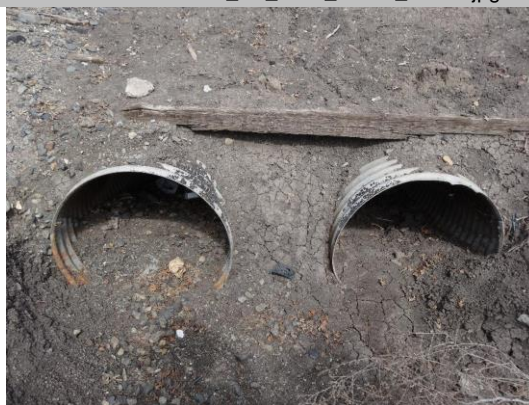
Photo 3 of 3 : UCIP_FA_2017_32704_59189.jpg

LS view: CMP inlet pipes on levee slope. Debris and mud on inlet ditch and inside the pipe.

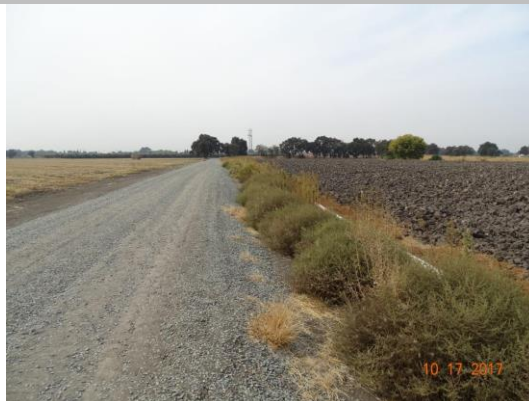
Photo 1 of 1 : FA_2017_NA0017_148_17_20171023_00056.jpg

LM Start	0.86	Rating **	M	Issue No.	17
LM End	1.26	Issue Type +	Ma	Location *	WS
Category	Earthen Levee			GPS Latitude/Longitude	
				Start	End
Item	Vegetation			37.878268 °	37.880138 °
				-121.243621 °	-121.249125 °
DWR ID	DWR_NA0017_01_f_2017_17				
Comment Code					
V1 : Control annual grass and weeds on the levee slopes and easements.					
Inspector Comment

View of the vegetation on the waterside shoulder of the levee looking downstream. Fall 2017

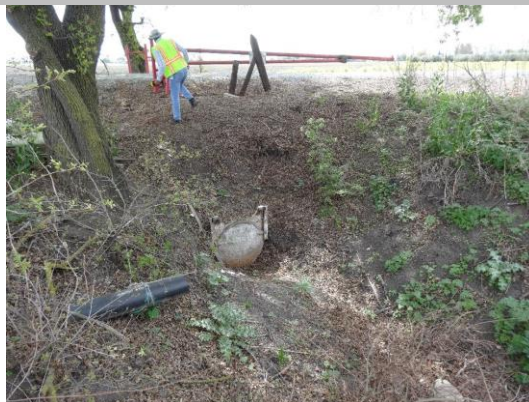
Photo 1 of 3 : UCIP_FA_2017_32746_59251.jpg

LM Start	1.02	Rating **	M	Issue No.	204
LM End	1.02	Issue Type +	Ma	Location *	
Category	Supplemental			GPS Latitude/Longitude	
				Start	End
Item	DWR UCIP LMA Responsibility			37.877566 °	37.877566 °
				-121.246391 °	-121.246391 °
DWR ID					
Comment Code					
Inspector Comment					
FS_ID:32746 DS_ID:23985 EP_NO: N/A Repair Type: Non-Urgent Crossing Status: Found UCIP Comments: Debris and mud on inlet ditch and inside pipe. Needs cleaning and clearing the culvert. FIELD_STRUCT_DESC: 30-inch corrugated metal drainage pipe through the levee, 11 feet below the crown. Flap gate on the waterside (WS). [Additional Reference(s): USACE San Joaquin O&M Manual 613C, Volume 15, May 1963, (Station 83+00)]. FS Date: 3/25/2014

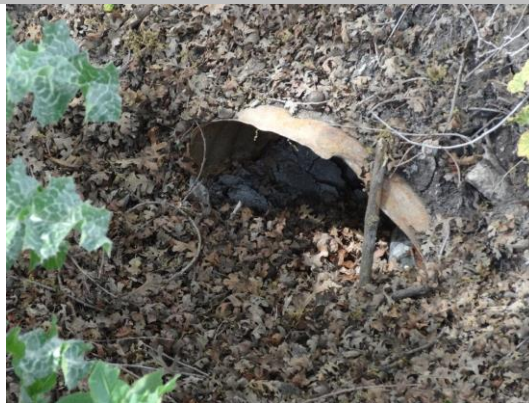
Photo 2 of 3 : UCIP_FA_2017_32746_59250.jpg

LS view: CMP inlet pipe on levee slope. Vegetation debris and mud on inlet ditch.

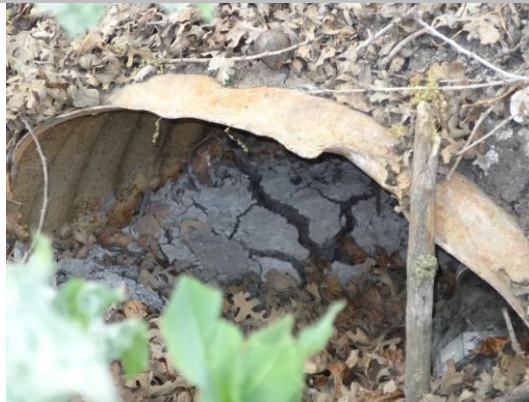
Photo 3 of 3 : UCIP_FA_2017_32746_59249.jpg

LS view: inside view of CM inlet pipe. Needs cleaning and clearing the culvert.

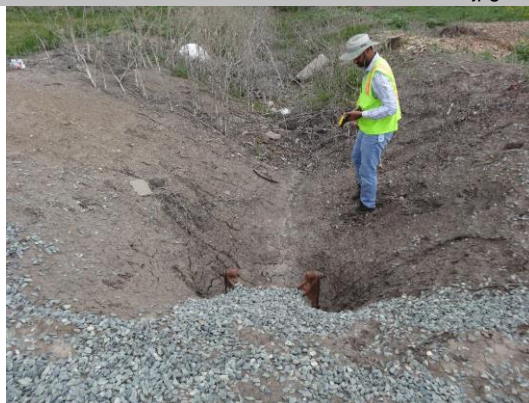
Photo 1 of 3 : UCIP_FA_2017_32747_59254.jpg

LM Start	1.18	Rating **	M	Issue No.	205
LM End	1.18	Issue Type +	Ma	Location *	
Category	Supplemental			GPS Latitude/Longitude	
				Start	End
Item	DWR UCIP LMA Responsibility			37.879076 °	37.879076 °
				-121.248304 °	-121.248304 °
DWR ID					
Comment Code					
Inspector Comment					
FS_ID:32747					
DS_ID:17970					
EP_NO: N/A					
Repair Type: Non-Urgent					
Crossing Status: Found					
UCIP Comments: Needs cleaning and clearing the culvert.					
FIELD_STRUCT_DESC: 24-inch corrugated metal drainage pipe through the levee, 4.1 feet below the crown. Flap gate on the waterside (WS) end. [Additional Reference(s): DWR Levee Log, 1977. USACE San Joaquin O&M Manual 613C, Volume 15, May 1963, (Station 76+60)].					
FS Date: 3/25/2014

WS view: CM drain pipe with flap gate on levee slope. Dirt spillway to the creek.

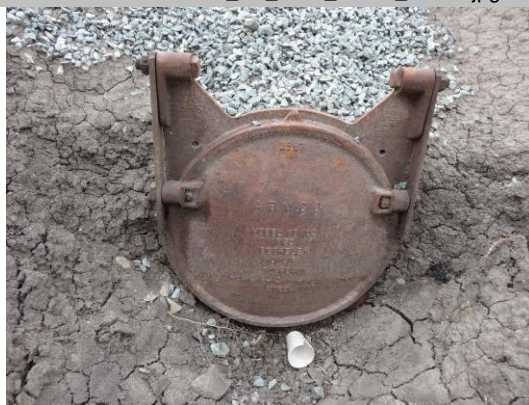
Photo 2 of 3 : UCIP_FA_2017_32747_59253.jpg

WS view: closer view of CM drain pipe with flap gate on levee slope.

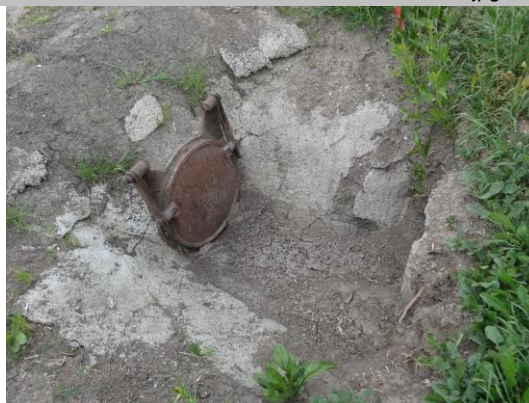
Photo 2 of 3 : UCIP_FA_2017_32652_59120.jpg

LM Start	2.53	Rating **	A/W	Issue No.	207 (cont)
LM End	2.53	Issue Type +	Ma	Location *	
Category	Supplemental			GPS Latitude/Longitude	
				Start	End
Item	DWR UCIP LMA Responsibility			37.888080 °	37.888080 °
				-121.266631 °	-121.266631 °
DWR ID					
Comment Code					
Inspector Comment					
FS_ID:32652 DS_ID:17966 EP_NO: N/A Repair Type: No Action Needed Crossing Status: Found UCIP Comments: Grouted riprap outlet box and concrete outfall pipe on waterside.Pipe not visible on landside. FIELD_STRUCT_DESC: 24-inch corrugated metal drainage pipe through the levee, 5 feet below the crown. Flap gate on the waterside (WS) end. Grouted riprap outlet box and concrete outfall pipe on the WS. [Additional Reference(s): DWR Levee Log, 1977. USACE San Joaquin O&M Manual 613C, Volume 15, May 1963, (Station 4+00)]. FS Date: 3/25/2014

WS view: outlet pipe with flap gate. Grouted riprap on spillway.

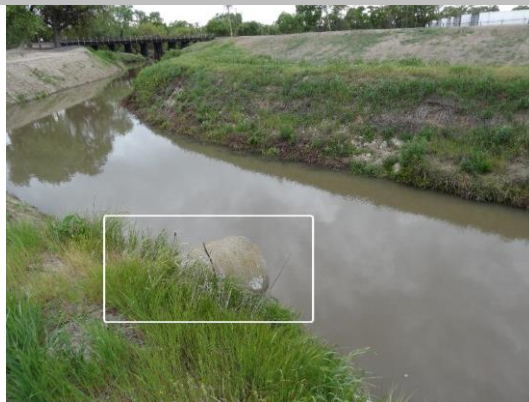
Photo 3 of 3 : UCIP_FA_2017_32652_59122.jpg

WS view: concrete outfall pipe on creek bank.

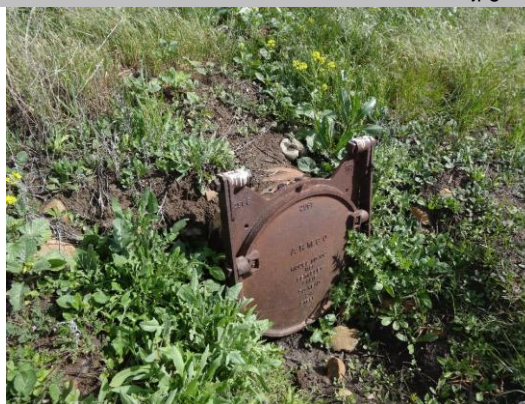
Photo 1 of 3 : UCIP_FA_2017_33124_59931.jpg

LM Start	0.50	Rating **	A/W	Issue No.	127
LM End	0.50	Issue Type +	Ma	Location *	
Category	Supplemental			GPS Latitude/Longitude	
				Start	End
Item	DWR UCIP LMA Responsibility			37.875178 °	37.875178 °
				-121.228514 °	-121.228514 °
DWR ID					
Comment Code					
Inspector Comment					
FS_ID:33124					
DS_ID:17986					
EP_NO: N/A					
Repair Type: No Action Needed					
Crossing Status: Found					
UCIP Comments: May need cleaning.					
FIELD_STRUCT_DESC: 24-inch corrugated metal drainage pipe					
through the levee, 5 feet below the crown. Flap gate on the waterside					
(WS) end. [Additional Reference(s): DWR Levee Log, 1977. USACE					
San Joaquin O&M Manual 613C, Volume 15, May 1963, (Station					
148+18N)].					
FS Date: 4/2/2014

WS view: CM drain pipe with flap gate on creek bank.

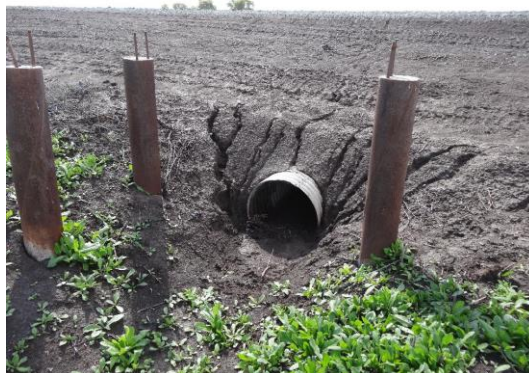
Photo 2 of 3 : UCIP_FA_2017_33124_59930.jpg

LS view: CM inlet pipe on levee slope. Mud on inlet ditch and pipe.

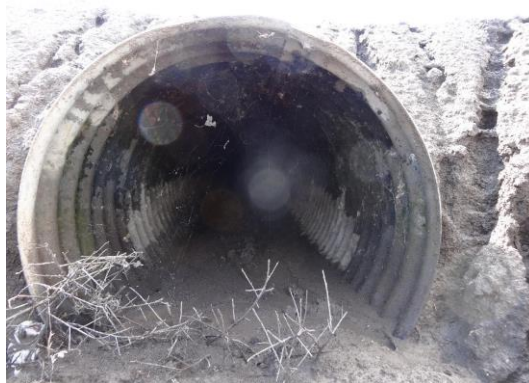
Photo 3 of 3 : UCIP_FA_2017_33124_59929.jpg

LS view: closer view of CM inlet pipe. Mud on inlet ditch and pipe. May need cleaning.

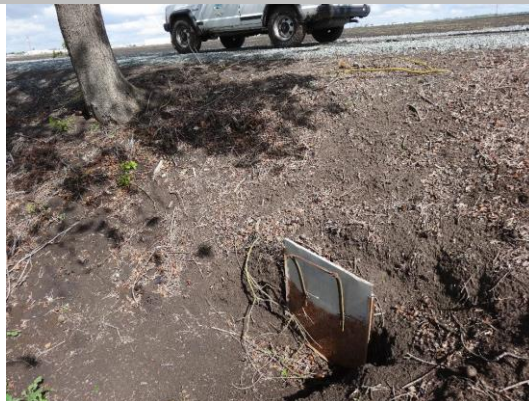
Photo 1 of 3 : UCIP_FA_2017_33125_59937.jpg

LM Start	1.06	Rating **	M	Issue No.	128
LM End	1.06	Issue Type +	Ma	Location *	
Category	Supplemental			GPS Latitude/Longitude	
				Start	End
Item	DWR UCIP LMA Responsibility			37.877386 °	37.877386 °
				-121.237044 °	-121.237044 °
DWR ID					
Comment Code					
Inspector Comment					
FS_ID:33125					
DS_ID:17983					
EP_NO: N/A					
Repair Type: Non-Urgent					
Crossing Status: Found					
UCIP Comments: Needs cleaning and clearing the culvert.					
FIELD_STRUCT_DESC: 24-inch corrugated metal drainage pipe					
through the levee, 6.4 feet below the crown. Flap gate on the waterside					
(WS) end. [Additional Reference(s): DWR Levee Log, 1977. USACE					
San Joaquin O&M Manual 613C, Volume 15, May 1963, (Station					
114+50)].					
FS Date: 4/2/2014

WS view: CM drain pipe with plate gate on levee slope.

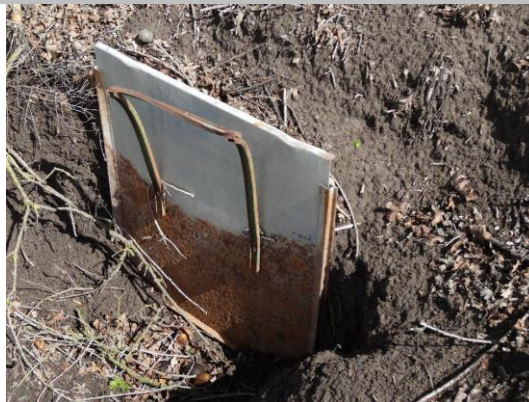
Photo 2 of 3 : UCIP_FA_2017_33125_59936.jpg

WS view: closer view of plate gate on the CM pipe end.

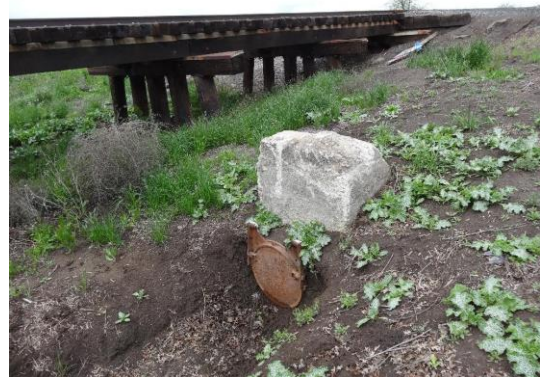
Photo 1 of 2 : UCIP_FA_2017_33144_59947.jpg

LM Start	1.47	Rating **	A/W	Issue No.	132	
LM End	1.47	Issue Type +	Ma	Location *		
Category	Supplemental			GPS Latitude/Longitude		
				Start	End	
Item	DWR UCIP LMA Responsibility			37.879657 °	37.879657 °	
				-121.243467 °	-121.243467 °	
DWR ID						
Comment Code						
Inspector Comment						
FS_ID:33144						
DS_ID:23984						
EP_NO: N/A						
Repair Type: No Action Needed						
Crossing Status: Found						
UCIP Comments: May need cleaning.						
FIELD_STRUCT_DESC: 24-inch corrugated metal drainage pipe with						
flap gate through the levee, at an unknown depth. [Additional						
Reference(s): USACE San Joaquin O&M Manual 613C, Volume 15,						
May 1963, (Station 93+00)].						
FS Date: 4/2/2014

WS view: CM drain pipe with flap gate on levee slope.

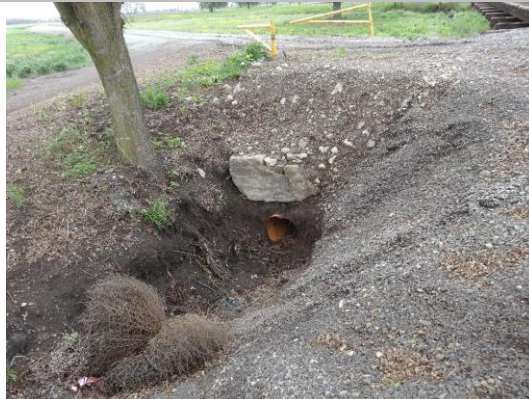
Photo 2 of 2 : UCIP_FA_2017_33144_59946.jpg

LS view: CM drain pipe on drainage ditch. Mud and vegetation debris on the pipe.

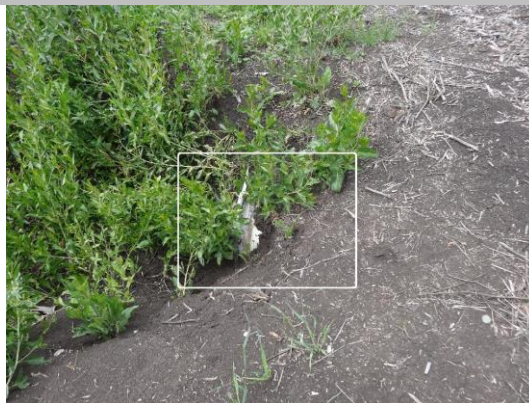
Photo 1 of 2 : UCIP_FA_2017_33163_59952.jpg

LM Start	1.48	Rating **	A/W	Issue No.	133
LM End	1.48	Issue Type +	Ma	Location *	
Category	Supplemental			GPS Latitude/Longitude	
				Start	End
Item	DWR UCIP LMA Responsibility			37.879603 °	37.879603 °
				-121.243671 °	-121.243671 °
DWR ID					
Comment Code					
Inspector Comment					
FS_ID:33163					
DS_ID:23998					
EP_NO: N/A					
Repair Type: No Action Needed					
Crossing Status: Found					
UCIP Comments: Galvanized iron plate slide gate on waterside. It is not not a old pipe. The plate gate looks new.					
FIELD_STRUCT_DESC: 16-inch high-density polyethylene drainage pipe through the levee, 7.7 feet below the crown. Galvanized iron plate gate on the waterside (WS) end. [Additional Reference(s): USACE San Joaquin O&M Manual 613C, Volume 15, May 1963, (Station 91+80) 12-inch steel pipe listed].					
FS Date: 4/2/2014

WS view: HDPE drain pipe on levee slope.

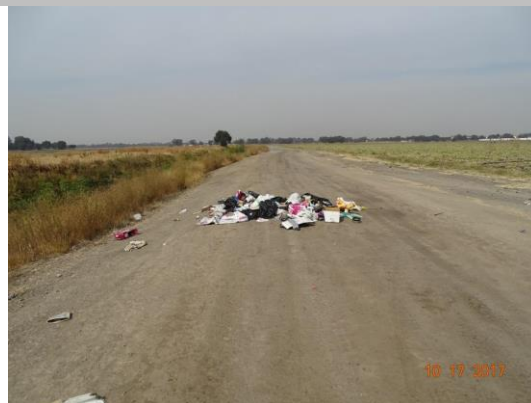
Photo 1 of 1 : FA_2017_NA0017_149_14_20171023_00036.jpg

LM Start	1.91	Rating **	M	Issue No.	14
LM End	1.91	Issue Type +	Ma	Location *	CR
Category	Earthen Levee			GPS Latitude/Longitude	
				Start	End
Item	Encroachments			37.881810 °	37.881810 °
				-121.249387 °	-121.249387 °
DWR ID	DWR_NA0017_02_f_2017_14				
Comment Code					
DE : Debris					
Inspector Comment

View of debris on the crown of the levee. Fall 2017

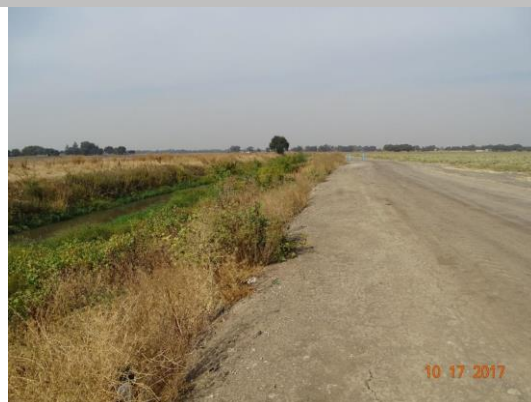
Photo 1 of 1 : FA_2017_NA0017_149_17_20171023_00037.jpg

LM Start	1.93	Rating **	M	Issue No.	17
LM End	2.98	Issue Type +	Ma	Location *	WS
Category	Earthen Levee			GPS Latitude/Longitude	
				Start	End
Item	Vegetation			37.881999 °	37.888205 °
				-121.249686 °	-121.264437 °
DWR ID	DWR_NA0017_02_f_2017_17				
Comment Code					
V1 : Control annual grass and weeds on the levee slopes and easements.					
Inspector Comment

View of vegetation on the waterside of the levee. Fall 2017

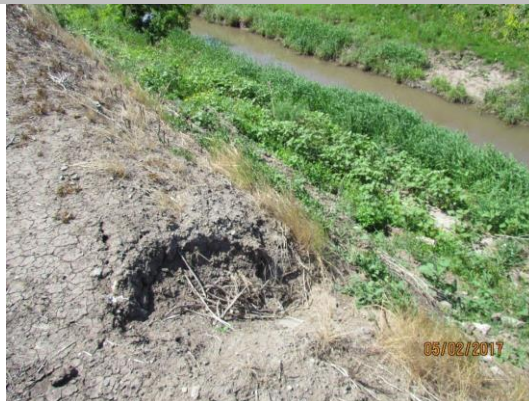
Photo 1 of 1 : FA_2017_NA0017_149_15_20170921_00002.jpg

LM Start	2.22	Rating **	M	Issue No.	15
LM End	2.22	Issue Type +	Ma	Location *	WS
Category	Earthen Levee			GPS Latitude/Longitude	
				Start	End
Item	Erosion / Bank Caving			37.884705 °	37.884705 °
				-121.253806 °	-121.253806 °
DWR ID	DWR_NA0017_02_s_2017_15				
Comment Code					
E1 : Note and monitor erosion site.					
Inspector Comment					
Erosion due to runoff.

View of an erosion due to runoff on the waterside shoulder of the levee.
Spring 2017

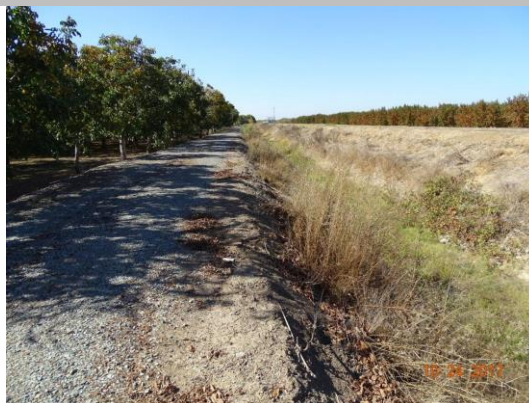
Photo 1 of 1 : FA_2017_NA0017_150_2_20171027_00006.jpg

LM Start	0.01	Rating **	M	Issue No.	2
LM End	0.19	Issue Type +	Ma	Location *	WS
Category	Earthen Levee			GPS Latitude/Longitude	
				Start	End
Item	Vegetation			37.979206 °	37.979273 °
				-121.098635 °	-121.095439 °
DWR ID	DWR_NA0017_06_f_2017_2				
Comment Code					
V1 : Control annual grass and weeds on the levee slopes and easements.					
Inspector Comment

View of vegetation on the waterside of the levee looking upstream. Fall 2017

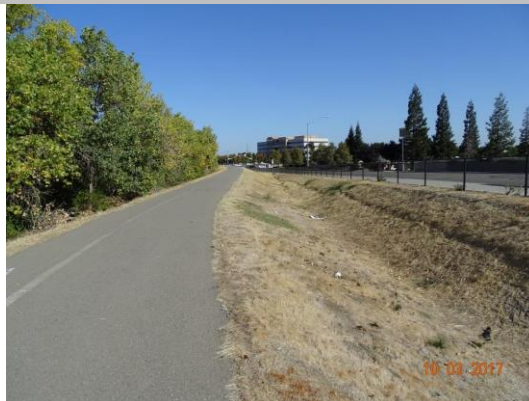
Photo 1 of 1 : FA_2017_NA0017_151_140_20171016_00546.jpg

LM Start	0.14	Rating **	A	Issue No.	140
LM End	0.14	Issue Type +	Ma	Location *	LS
Category	Earthen Levee			GPS Latitude/Longitude	
				Start	End
Item	Vegetation			38.043965 °	38.043965 °
				-121.370682 °	-121.370682 °
DWR ID	DWR_NA0017_07_f_2017_140				
Comment Code					
V1 : Control annual grass and weeds on the levee slopes and easements.					
Inspector Comment					
Acceptable vegetation.

View of the landside slope of the levee. Fall 2017

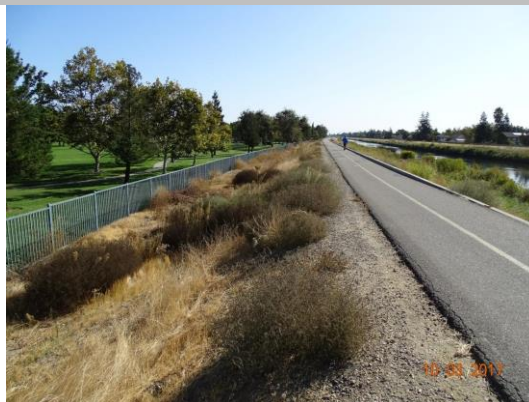
Photo 1 of 1 : FA_2017_NA0017_151_69_20171016_00547.jpg

LM Start	0.38	Rating **	M	Issue No.	69
LM End	1.31	Issue Type +	Ma	Location *	LS
Category	Earthen Levee			GPS Latitude/Longitude	
				Start	End
Item	Vegetation			38.043596 °	38.043274 °
				-121.366714 °	-121.349704 °
DWR ID	DWR_NA0017_07_s_2017_69				
Comment Code					
V2 : Remove the wild growth other than native grasses from the levee slopes.					
Inspector Comment

View of vegetation on the landside of the levee looking upstream. Fall 2017

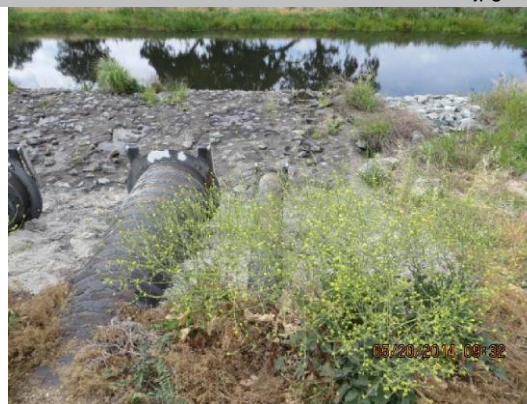
Photo 1 of 2 : UCIP_FA_2017_38092_69303.jpg

Pipe and flapgate visible on WS slope.

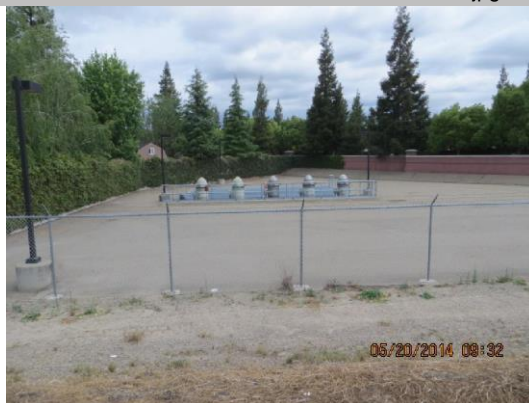
Photo 2 of 2 : UCIP_FA_2017_38092_69302.jpg

Pump over sump off LS toe.

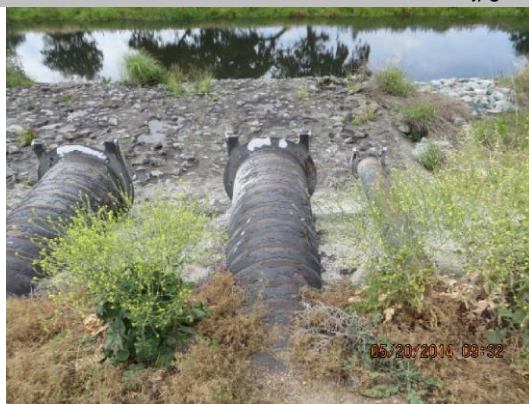
Photo 1 of 2 : UCIP_FA_2017_38093_69305.jpg

Pipe and flapgate visible on WS slope.

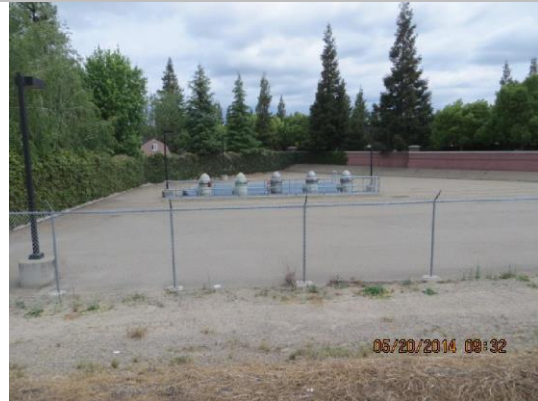
Photo 2 of 2 : UCIP_FA_2017_38086_69290.jpg

Pump over sump off LS toe.

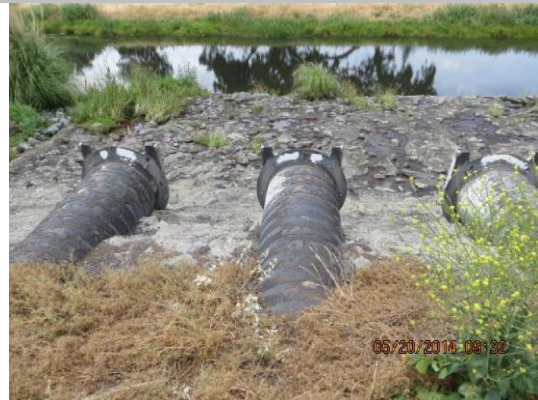
Photo 1 of 2 : UCIP_FA_2017_38089_69297.jpg

Pipe and flapgate visible on WS slope.

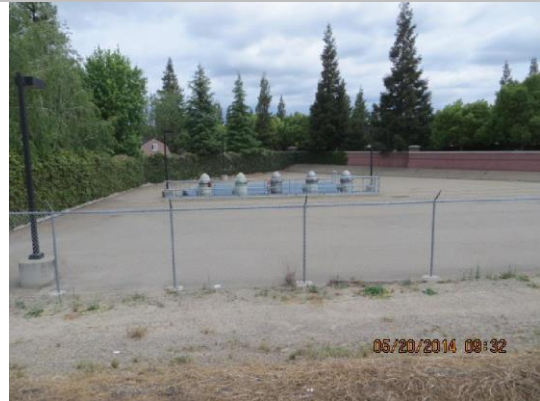
Photo 2 of 2 : UCIP_FA_2017_38089_69296.jpg

Pump over sump off LS toe.

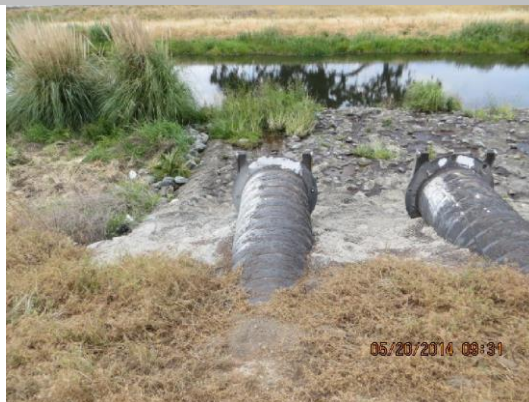
Photo 1 of 2 : UCIP_FA_2017_38087_69293.jpg

Pipe and flapgate on WS slope.

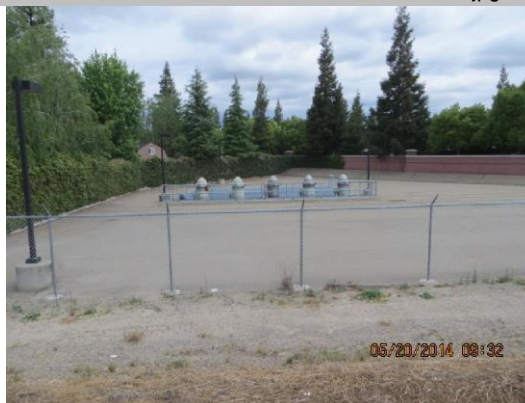
Photo 2 of 2 : UCIP_FA_2017_38087_69292.jpg

Pump over sump off LS toe.

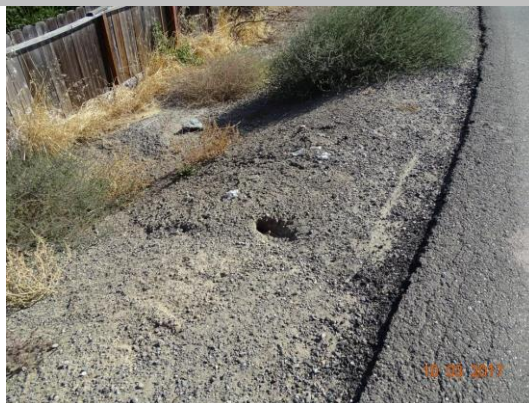
Photo 1 of 1 : FA_2017_NA0017_151_142_20171016_00549.jpg

LM Start	1.77	Rating **	M	Issue No.	142
LM End	1.77	Issue Type +	Ma	Location *	LS
Category	Earthen Levee			GPS Latitude/Longitude	
				Start	End
Item	Animal Control			38.043290 °	38.043290 °
				-121.341189 °	-121.341189 °
DWR ID	DWR_NA0017_07_f_2017_142				
Comment Code					
A3 : No rodents visible, but rodent burrows visible; need to backfill and compact or grout burrows.					
Inspector Comment

View of a rodent hole on the landside shoulder of the levee. Fall 2017

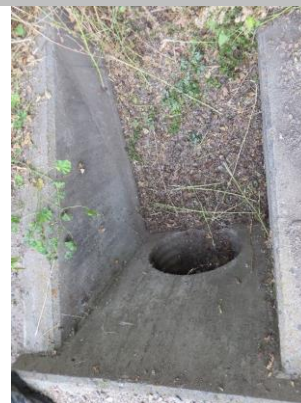
Photo 3 of 3 : UCIP_FA_2017_38024_69203.jpg

Headwall at LS toe.

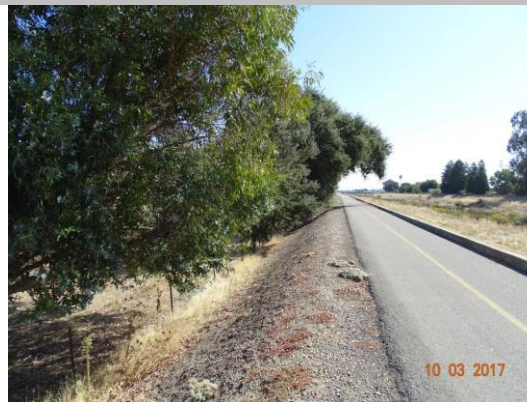
Photo 1 of 1 : FA_2017_NA0017_151_149_20171016_00550.jpg

LM Start	2.49	Rating **	M	Issue No.	149
LM End	2.71	Issue Type +	Ma	Location *	LS
Category	Earthen Levee			GPS Latitude/Longitude	
				Start	End
Item	Trim / Thin Trees			38.043166 °	38.043163 °
				-121.327967 °	-121.323913 °
DWR ID	DWR_NA0017_07_s_2017_149				
Comment Code					
T1 : Trim trees to at least five feet above ground level.					
Inspector Comment

Tree limbs obstruction view of the landside slope of the levee looking upstream.

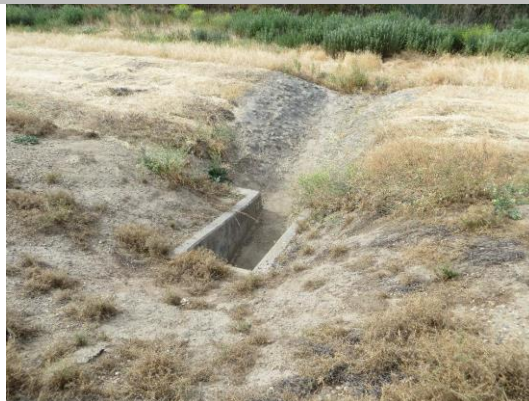
Photo 1 of 3 : UCIP_FA_2017_38006_69190.jpg

Headwall, flapgate, and grouted spillway on WS toe.

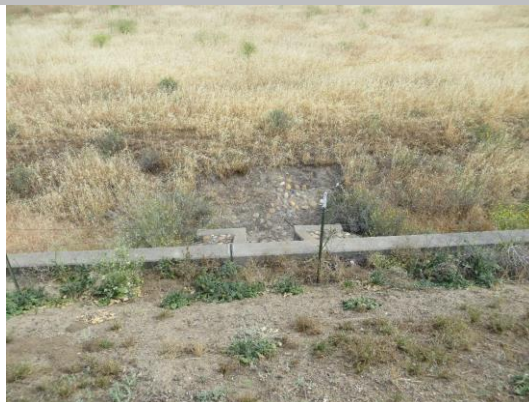
Photo 2 of 3 : UCIP_FA_2017_38006_69189.jpg

Headwall at inlet on LS toe.

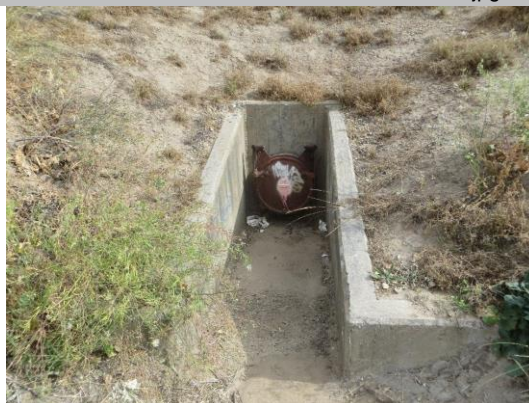
Photo 3 of 3 : UCIP_FA_2017_38006_69188.jpg

Headwall and flapgate at WS toe.

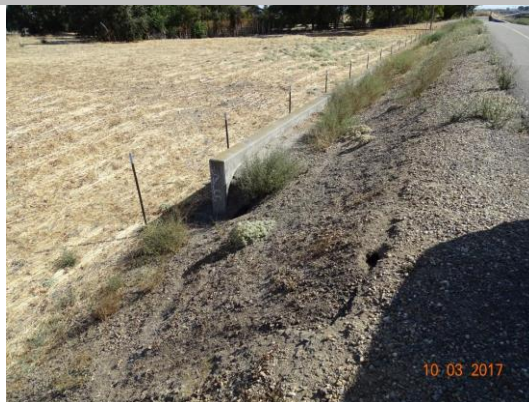
Photo 1 of 1 : FA_2017_NA0017_151_145_20171016_00552.jpg

LM Start	2.71	Rating **	M	Issue No.	145
LM End	2.71	Issue Type +	Ma	Location *	LS
Category	Earthen Levee			GPS Latitude/Longitude	
				Start	End
Item	Animal Control			38.043163 °	38.043163 °
				-121.323913 °	-121.323913 °
DWR ID	DWR_NA0017_07_f_2017_145				
Comment Code					
A3 : No rodents visible, but rodent burrows visible; need to backfill and compact or grout burrows.					
Inspector Comment

View of rodent holes on the landside of the levee looking upstream. Fall 2017

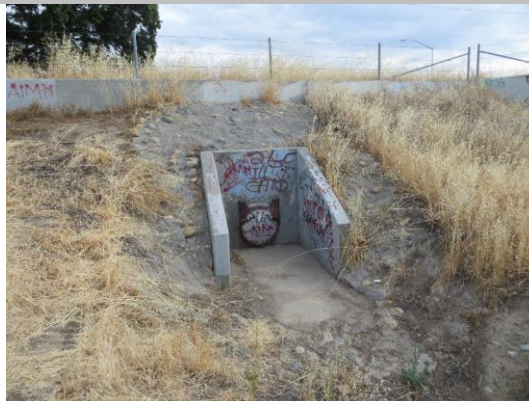
Photo 1 of 3 : UCIP_FA_2017_38004_69184.jpg

LM Start	2.80	Rating **	A/W	Issue No.	1067	
LM End	2.80	Issue Type +	Ma	Location *		
Category	Supplemental			GPS Latitude/Longitude		
				Start	End	
Item	DWR UCIP LMA Responsibility			38.043164 °	38.043164 °	
				-121.322283 °	-121.322283 °	
DWR ID						
Comment Code						
Inspector Comment						
FS_ID:38004						
DS_ID:23525						
EP_NO: N/A						
Repair Type: No Action Needed						
Crossing Status: Found						
UCIP Comments:						
FIELD_STRUCT_DESC: 24-inch corrugated metal drainage pipe through the levee, 8 feet below the crown. Concrete U-shaped headwalls on both ends. Flap gate on the waterside (WS) end. Cobble grouted spillway across the berm. [Additional Reference(s): DWR Levee Log, 1987. USACE San Joaquin O&M Manual 612.1, June 1965, (HLM 3.09)].						
FS Date: 5/20/2014

Headwall and flapgate on WS slope.

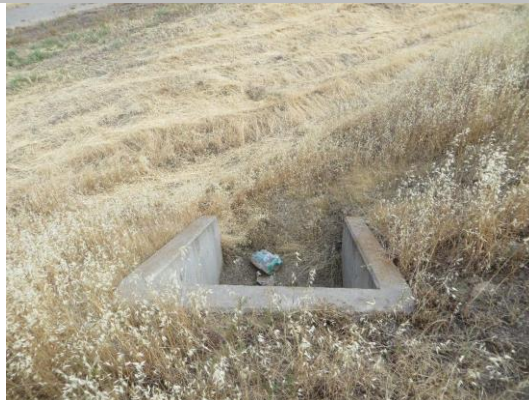
Photo 2 of 3 : UCIP_FA_2017_38004_69183.jpg

Headwall at LS toe.

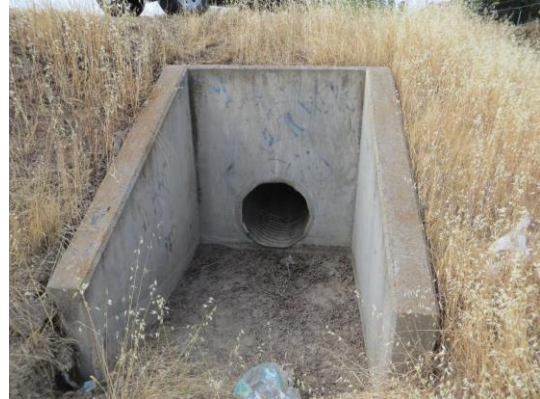
Photo 3 of 3 : UCIP_FA_2017_38004_69182.jpg

Headwall at LS toe.

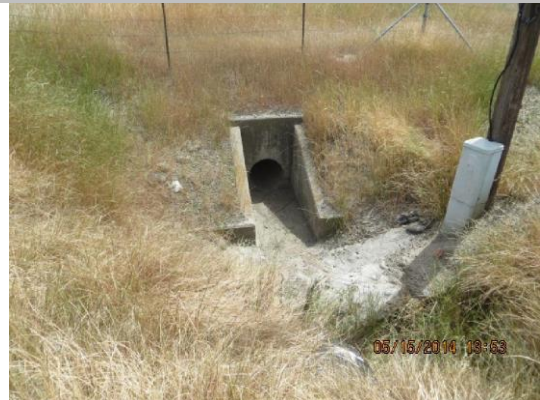
Photo 1 of 3 : UCIP_FA_2017_37999_69164.jpg

LM Start	2.83	Rating **	A/W	Issue No.	1068
LM End	2.83	Issue Type +	Ma	Location *	
Category	Supplemental			GPS Latitude/Longitude	
				Start	End
Item	DWR UCIP LMA Responsibility			38.043199 °	38.043199 °
				-121.321841 °	-121.321841 °
DWR ID					
Comment Code					
Inspector Comment					
FS_ID:37999 DS_ID:23526 EP_NO: N/A Repair Type: No Action Needed Crossing Status: Found UCIP Comments: FIELD_STRUCT_DESC: 24-inch corrugated metal storm drainage pipe through the levee, 7.5 feet below the crown. Concrete U-shaped headwalls on both ends. Flap gate on the waterside (WS) end. Cobble grouted spillway across the berm. [Additional Reference(s): DWR Levee Log, 1987. USACE San Joaquin O&M Manual 612.1, June 1965, (HLM 3.12) and 612 (addendum), February 1999, (HLM 3.15) (Station 166+25)]. FS Date: 5/15/2014

Headwall at LS toe.

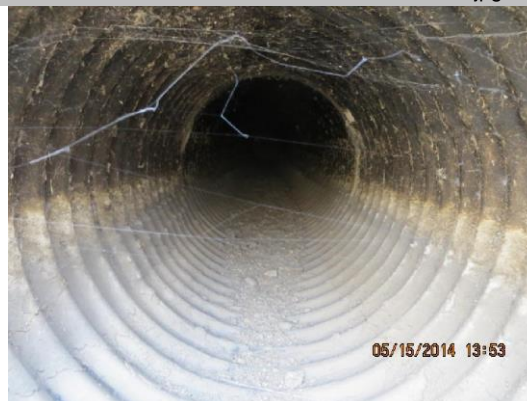
Photo 2 of 3 : UCIP_FA_2017_37999_69163.jpg

Inside pipe at LS toe.

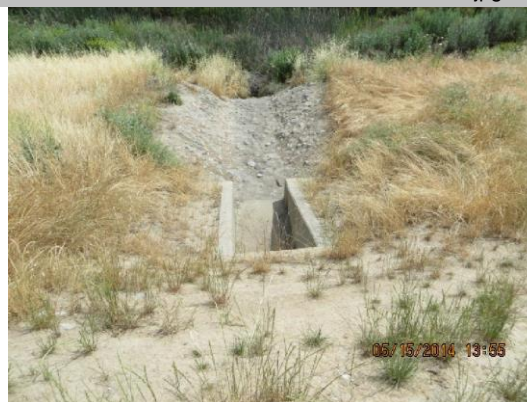
Photo 3 of 3 : UCIP_FA_2017_37999_69162.jpg

Headwall and flapgate at WS toe.

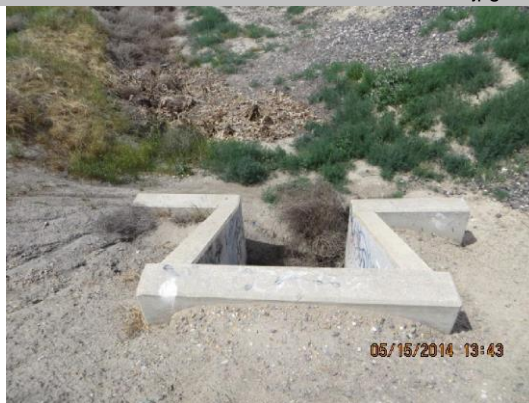
Photo 1 of 3 : UCIP_FA_2017_37998_69160.jpg

LM Start	3.06	Rating **	A/W	Issue No.	1069
LM End	3.06	Issue Type +	Ma	Location *	
Category	Supplemental			GPS Latitude/Longitude	
				Start	End
Item	DWR UCIP LMA Responsibility			38.043195 °	38.043195 °
				-121.317498 °	-121.317498 °
DWR ID					
Comment Code					
Inspector Comment					
FS_ID:37998					
DS_ID:23528					
EP_NO: N/A					
Repair Type: No Action Needed					
Crossing Status: Found					
UCIP Comments:					
FIELD_STRUCT_DESC: 42-inch corrugated metal drainage pipe through the levee, 7.3 feet below the crown. Concrete U-shaped headwall on both sides. Flap gate on the waterside (WS) end. Grouted intake on the landside (LS). Cobble grouted spillway across the berm. [Additional Reference(s): DWR Levee Log, 1987. USACE San Joaquin O&M Manual 612.1, June 1965, (HLM 3.36)].					
FS Date: 5/15/2014

Headwall on LS slope.

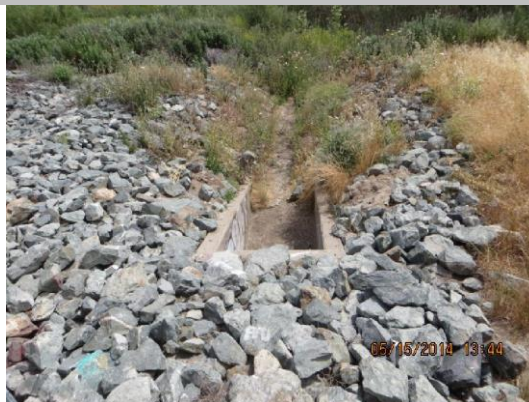
Photo 2 of 3 : UCIP_FA_2017_37998_69159.jpg

Headwall and flapgate on WS toe.

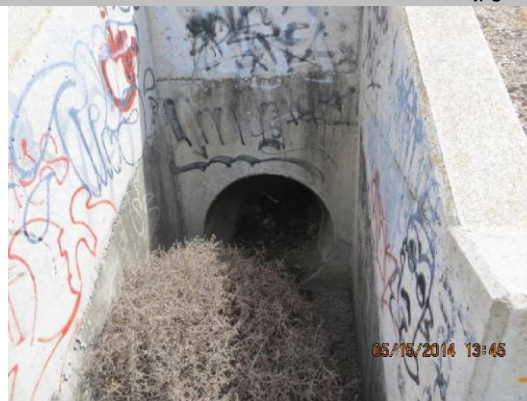
Photo 3 of 3 : UCIP_FA_2017_37998_69158.jpg

Headwall on LS slope.

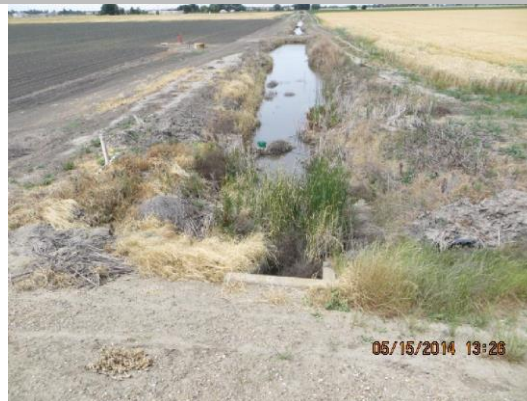
Photo 1 of 3 : UCIP_FA_2017_37991_69144.jpg

LM Start	3.27	Rating **	A/W	Issue No.	1071
LM End	3.27	Issue Type +	Ma	Location *	
Category	Supplemental			GPS Latitude/Longitude	
				Start	End
Item	DWR UCIP LMA Responsibility			38.043193 °	38.043193 °
				-121.313684 °	-121.313684 °
DWR ID					
Comment Code					
Inspector Comment					
FS_ID:37991 DS_ID:23532 EP_NO: N/A Repair Type: No Action Needed Crossing Status: Found UCIP Comments: FIELD_STRUCT_DESC: 36-inch corrugated metal drainage pipe through the levee, 8.5 feet below the crown. Concrete U-shaped headwalls on both ends. Flap gate on the waterside (WS) end. Cobble grouted spillway across berm. [Additional Reference(s): DWR Levee Log, 1987. USACE San Joaquin O&M Manual 612.1, June 1965, (HLM 3.58)]. FS Date: 5/15/2014

Headwall at LS toe.

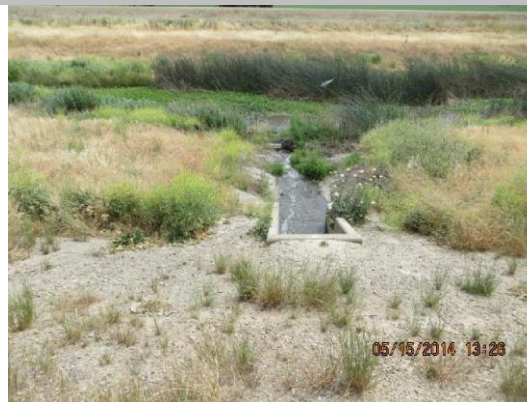
Photo 2 of 3 : UCIP_FA_2017_37991_69143.jpg

Headwall and flapgate at WS toe.

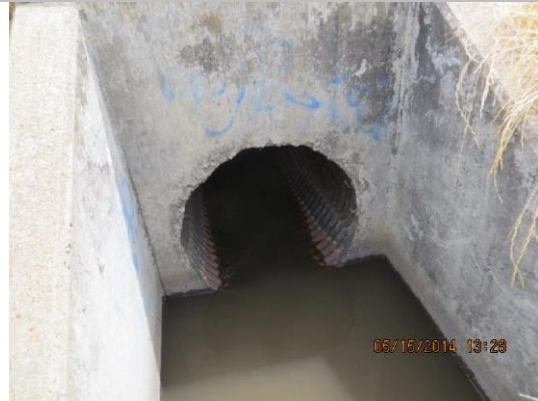
Photo 3 of 3 : UCIP_FA_2017_37991_69142.jpg

Headwall at LS toe.

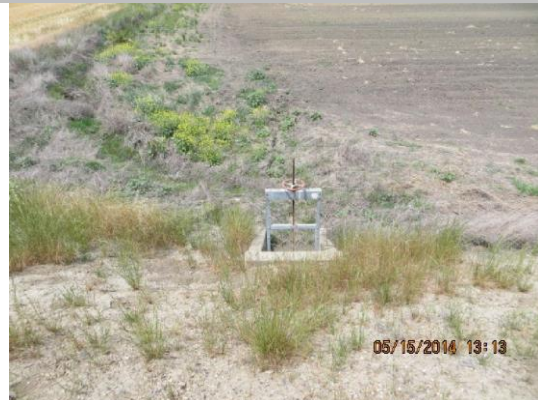
Photo 1 of 3 : UCIP_FA_2017_37988_69139.jpg

LM Start	3.49	Rating **	A/W	Issue No.	1072
LM End	3.49	Issue Type +	Ma	Location *	
Category	Supplemental			GPS Latitude/Longitude	
				Start	End
Item	DWR UCIP LMA Responsibility			38.043048 °	38.043048 °
				-121.309641 °	-121.309641 °
DWR ID					
Comment Code					
Inspector Comment					
FS_ID:37988 DS_ID:23533 EP_NO: N/A Repair Type: No Action Needed Crossing Status: Found UCIP Comments: FIELD_STRUCT_DESC: 24-inch corrugated metal drainage pipe through the levee, 7 feet below the crown. Concrete U-shaped headwalls on both ends. Flap gate on the waterside (WS) end. Slide gate on the landside (LS) end. Grouted intake on the LS. Cobble grouted spillway across berm. [Additional Reference(s): DWR Levee Log, 1987. USACE San Joaquin O&M Manual 612.1, June 1965, (HLM 3.81)]. FS Date: 5/15/2014

Headwall and slidegate on LS toe.

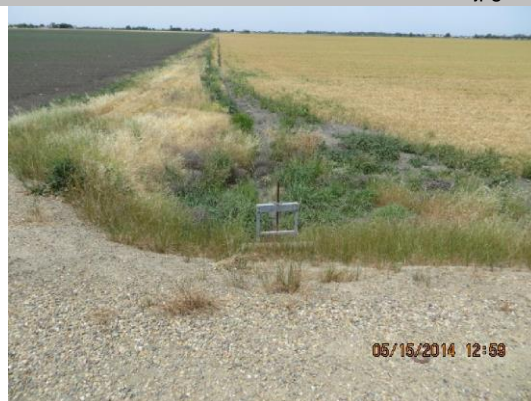
Photo 1 of 3 : UCIP_FA_2017_37984_69129.jpg

FS_ID:37984
DS_ID:23534
EP_NO: N/A
Repair Type: No Action Needed
Crossing Status: Found
UCIP Comments:
FIELD_STRUCT_DESC: 24-inch corrugated metal storm drainage pipe through the levee, 7 feet below the crown. Concrete U-shaped headwalls on both ends. Flap gate on the waterside (WS) end. Slide gate on the landside (LS) end. Grouted intake on the LS. Cobble grouted spillway across the berm. [Additional Reference(s): DWR Levee Log, 1987. USACE San Joaquin O&M Manual 612.1, June 1965, (HLM 4.10) and 612 (addendum), February 1999, (HLM 4.10) (Station 216+43)].
FS Date: 5/15/2014

Slidegate at headwall on LS toe.

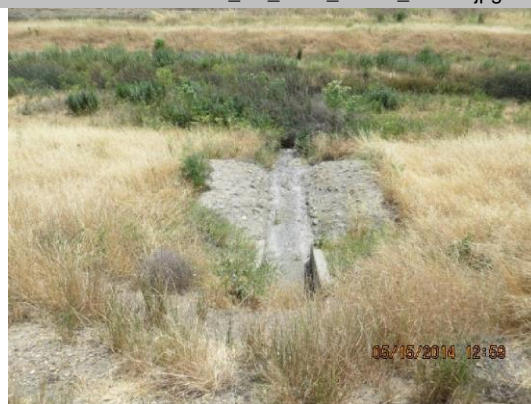
Photo 2 of 3 : UCIP_FA_2017_37984_69128.jpg

Headwall and flapgate at WS toe.

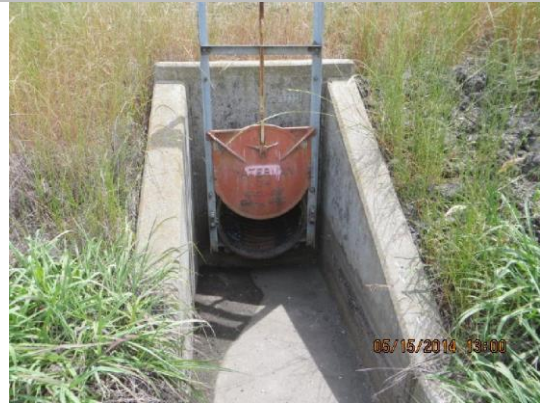
Photo 3 of 3 : UCIP_FA_2017_37984_69127.jpg

Slidegate at headwall on LS toe.

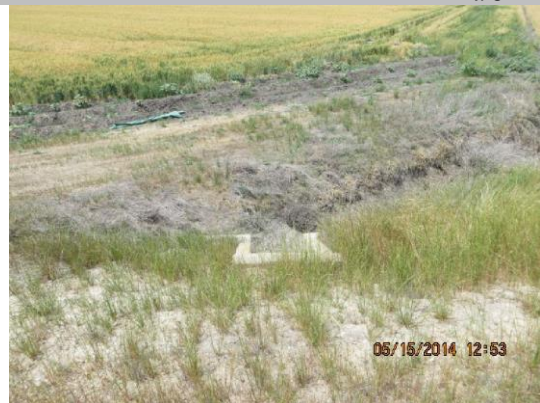
Photo 1 of 3 : UCIP_FA_2017_37982_69125.jpg

LM Start	4.05	Rating **	A/W	Issue No.	1074
LM End	4.05	Issue Type +	Ma	Location *	
Category	Supplemental			GPS Latitude/Longitude	
				Start	End
Item	DWR UCIP LMA Responsibility			38.043975 °	38.043975 °
				-121.299901 °	-121.299901 °
DWR ID					
Comment Code					
Inspector Comment					
FS_ID:37982					
DS_ID:23535					
EP_NO: N/A					
Repair Type: No Action Needed					
Crossing Status: Found					
UCIP Comments:					
FIELD_STRUCT_DESC: 24-inch corrugated metal storm drainage pipe through the levee, 8 feet below the crown. Concrete U-shaped headwalls on both ends. Flap gate on the waterside (WS) end. Grouted intake on the landside (LS). Cobble grouted spillway across the berm. [Additional Reference(s): DWR Levee Log, 1987. USACE San Joaquin O&M Manual 612.1, June 1965, (HLM 4.37) and 612 (addendum), February 1999, (HLM 4.33) (Station 228+58)].					
FS Date: 5/15/2014

Headwall at LS toe.

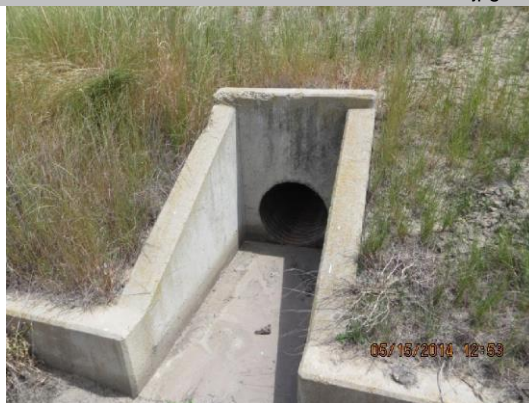
Photo 2 of 3 : UCIP_FA_2017_37982_69124.jpg

Headwall at LS toe.

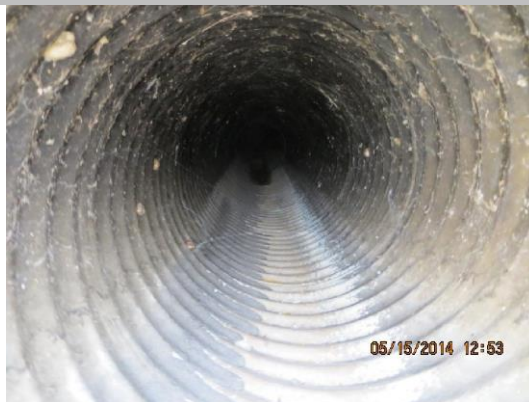
Photo 3 of 3 : UCIP_FA_2017_37982_69123.jpg

Inside pipe at LS toe.

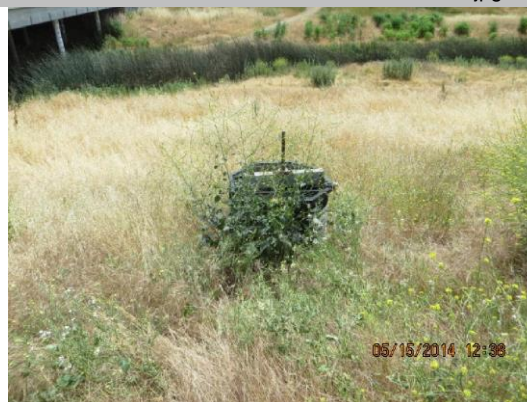
Photo 2 of 3 : UCIP_FA_2017_37981_69121.jpg

Slidegate in CMP riser on WS slope.

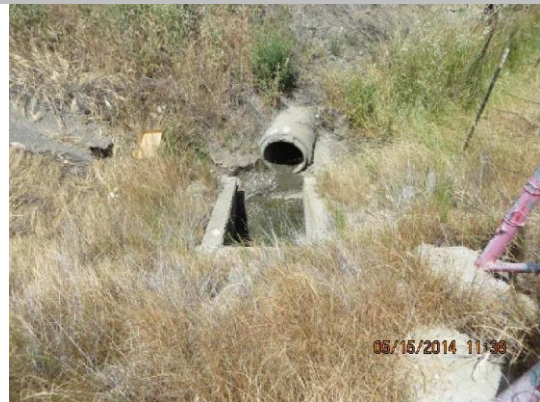
Photo 1 of 3 : UCIP_FA_2017_37973_69105.jpg

LM Start	4.33	Rating **	A/W	Issue No.	1077
LM End	4.33	Issue Type +	Ma	Location *	
Category	Supplemental			GPS Latitude/Longitude	
				Start	End
Item	DWR UCIP LMA Responsibility			38.044917 °	38.044917 °
				-121.295062 °	-121.295062 °
DWR ID					
Comment Code					
Inspector Comment					
FS_ID:37973					
DS_ID:23538					
EP_NO: N/A					
Repair Type: No Action Needed					
Crossing Status: Found					
UCIP Comments:					
FIELD_STRUCT_DESC: 24-inch corrugated metal drainage pipe through the levee, 8.3 feet below the crown. Concrete U-shaped headwalls on both ends. Flap gate on the waterside (WS) end. Grouted intake on the landside (LS). Cobble grouted spillway across berm. [Additional Reference(s): DWR Levee Log, 1987. USACE San Joaquin O&M Manual 612.1, June 1965, (HLM 4.66)].					
FS Date: 5/15/2014

Headwall on LS toe.

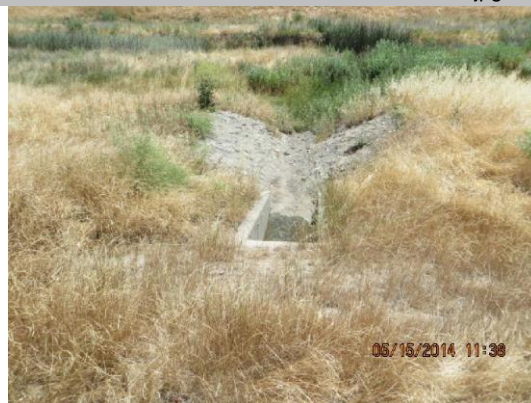
Photo 2 of 3 : UCIP_FA_2017_37973_69104.jpg

LM Start	4.33	Rating **	A/W	Issue No.	1077 (cont)	
LM End	4.33	Issue Type +	Ma	Location *		
Category	Supplemental			GPS Latitude/Longitude		
				Start		End
Item	DWR UCIP LMA Responsibility			38.044917 °		38.044917 °
				-121.295062 °		-121.295062 °
DWR ID						
Comment Code						
Inspector Comment						
FS_ID:37973						
DS_ID:23538						
EP_NO: N/A						
Repair Type: No Action Needed						
Crossing Status: Found						
UCIP Comments:						
FIELD_STRUCT_DESC: 24-inch corrugated metal drainage pipe through the levee, 8.3 feet below the crown. Concrete U-shaped headwalls on both ends. Flap gate on the waterside (WS) end. Grouted intake on the landside (LS). Cobble grouted spillway across berm. [Additional Reference(s): DWR Levee Log, 1987. USACE San Joaquin O&M Manual 612.1, June 1965, (HLM 4.66)].						
FS Date: 5/15/2014

Headwall, flapgate, and grouted spillway on WS toe.

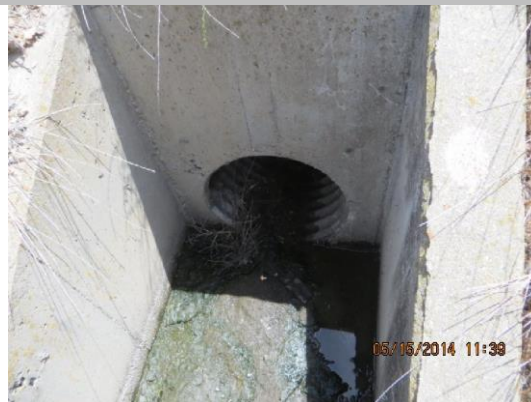
Photo 3 of 3 : UCIP_FA_2017_37973_69103.jpg

Headwall on LS toe.

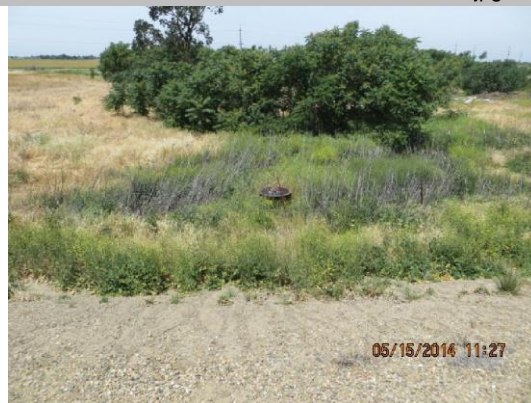
Photo 1 of 3 : UCIP_FA_2017_37969_69093.jpg

LM Start	4.48	Rating **	A/W	Issue No.	1078	
LM End	4.48	Issue Type +	Ma	Location *		
Category	Supplemental			GPS Latitude/Longitude		
				Start	End	
Item	DWR UCIP LMA Responsibility			38.046745 °	38.046745 °	
				-121.293602 °	-121.293602 °	
DWR ID						
Comment Code						
Inspector Comment						
FS_ID:37969 DS_ID:23539 EP_NO: N/A Repair Type: No Action Needed Crossing Status: Found UCIP Comments: FIELD_STRUCT_DESC: 8-inch pipe of an unknown material or unknown purpose through the levee, 9.4 feet below the crown. Flap gate on the waterside (WS) end. 40-inch corrugated metal riser unit with slide gate on the landside (LS) toe. [Additional Reference(s): DWR Levee Log, 1987. USACE San Joaquin O&M Manual 612.1, June 1965, (HLM 4.82)]. FS Date: 5/15/2014

CMP riser with slide gate on LS toe.
