**Flood Control Project Maintenance
Levee Inspections**

Maintenance Issue Types Only, Levee Inspection Report By Mile - Fall 2017

San Joaquin County Flood Control and Water Conservation District

Waterway	Bank	Unit Miles	Inspection Start/End	Inspector
Unit No. 01 Littlejohn Creek	Left	2.59	10/17/2017 10/17/2017	Pavel Kazi

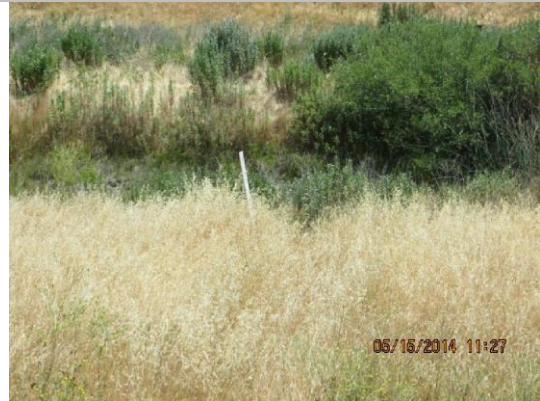
Photo 3 of 3 : UCIP_FA_2017_37969_69091.jpg

LM Start	4.48	Rating **	A/W	Issue No.	1078 (cont)	
LM End	4.48	Issue Type +	Ma	Location *		
Category	Supplemental			GPS Latitude/Longitude		
				Start	End	
Item	DWR UCIP LMA Responsibility			38.046745 °	38.046745 °	
				-121.293602 °	-121.293602 °	
DWR ID						
Comment Code						
Inspector Comment						
FS_ID:37969						
DS_ID:23539						
EP_NO: N/A						
Repair Type: No Action Needed						
Crossing Status: Found						
UCIP Comments:						
FIELD_STRUCT_DESC: 8-inch pipe of an unknown material or unknown purpose through the levee, 9.4 feet below the crown. Flap gate on the waterside (WS) end. 40-inch corrugated metal riser unit with slide gate on the landside (LS) toe. [Additional Reference(s): DWR Levee Log, 1987. USACE San Joaquin O&M Manual 612.1, June 1965, (HLM 4.82)].						
FS Date: 5/15/2014

Paddle/micarta sign marks pipe at outlet on WS toe.

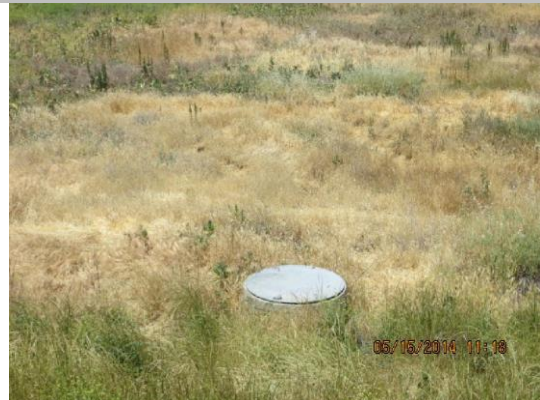
Photo 1 of 3 : UCIP_FA_2017_37967_69085.jpg

LM Start	4.54	Rating **	A/W	Issue No.	1079
LM End	4.54	Issue Type +	Ma	Location *	
Category	Supplemental			GPS Latitude/Longitude	
				Start	End
Item	DWR UCIP LMA Responsibility			38.047472 °	38.047472 °
				-121.293007 °	-121.293007 °
DWR ID					
Comment Code					
Inspector Comment					
FS_ID:37967 DS_ID:23540 EP_NO: N/A Repair Type: No Action Needed Crossing Status: Found UCIP Comments: FIELD_STRUCT_DESC: 24-inch corrugated metal storm drainage pipe through the levee, 8.8 feet below the crown. 44-inch concrete standpipe on the landside (LS) toe. Concrete U-shaped headwall on the waterside (WS) end. Flap gate on the WS end. Cobble grouted spillway across the berm. [Additional Reference(s): DWR Levee Log, 1987. USACE San Joaquin O&M Manual 612.1, June 1965, (HLM 4.88) and 612 (addendum), February 1999, (HLM 4.88) (Station 257+60)]. FS Date: 5/15/2014

Concrete standpipe on LS toe.

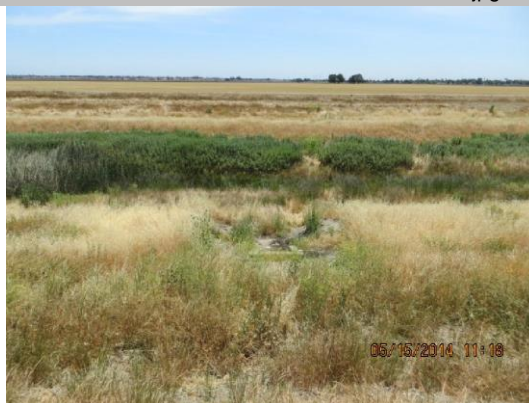
Photo 2 of 3 : UCIP_FA_2017_37967_69084.jpg

Headwall and flapgate on WS toe.

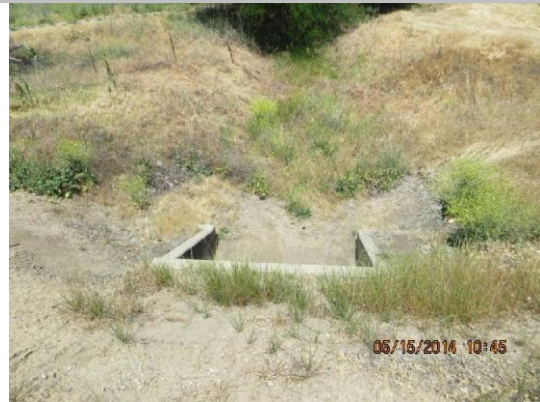
Photo 1 of 3 : UCIP_FA_2017_37957_69055.jpg

LM Start	4.97	Rating **	A/W	Issue No.	1081
LM End	4.97	Issue Type +	Ma	Location *	
Category	Supplemental			GPS Latitude/Longitude	
				Start	End
Item	DWR UCIP LMA Responsibility			38.050685 °	38.050685 °
				-121.286569 °	-121.286569 °
DWR ID					
Comment Code					
Inspector Comment					
FS_ID:37957					
DS_ID:23543					
EP_NO: N/A					
Repair Type: No Action Needed					
Crossing Status: Found					
UCIP Comments:					
FIELD_STRUCT_DESC: 1 of 2: 36-inch corrugated metal storm drainage pipe through the levee, 8.9 feet below the crown. Concrete U-shaped headwall on both ends. Flap gate on the waterside (WS) end. Grouted intake on the landside (LS). Cobble grouted spillway across the berm. [Additional Reference(s): DWR Levee Log, 1987. USACE San Joaquin O&M Manual 612.1, June 1965, (HLM 5.33) and 612 (addendum), February 1999, (HLM 5.37) (Station 283+76)].					
FS Date: 5/15/2014

Headwall on LS toe.

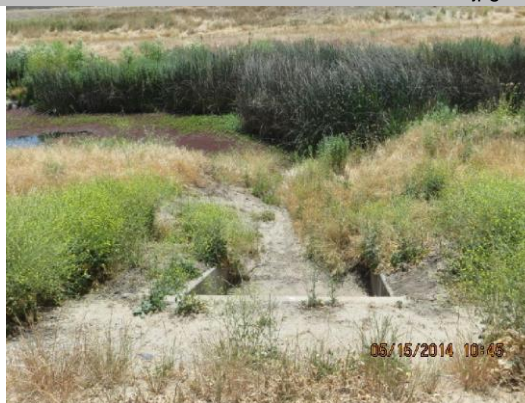
Photo 2 of 3 : UCIP_FA_2017_37957_69054.jpg

LM Start	4.97	Rating **	A/W	Issue No.	1081 (cont)	
LM End	4.97	Issue Type +	Ma	Location *		
Category	Supplemental			GPS Latitude/Longitude		
				Start	End	
Item	DWR UCIP LMA Responsibility			38.050685 °	38.050685 °	
				-121.286569 °	-121.286569 °	
DWR ID						
Comment Code						
Inspector Comment						
FS_ID:37957 DS_ID:23543 EP_NO: N/A Repair Type: No Action Needed Crossing Status: Found UCIP Comments: FIELD_STRUCT_DESC: 1 of 2: 36-inch corrugated metal storm drainage pipe through the levee, 8.9 feet below the crown. Concrete U-shaped headwall on both ends. Flap gate on the waterside (WS) end. Grouted intake on the landside (LS). Cobble grouted spillway across the berm. [Additional Reference(s): DWR Levee Log, 1987. USACE San Joaquin O&M Manual 612.1, June 1965, (HLM 5.33) and 612 (addendum), February 1999, (HLM 5.37) (Station 283+76)]. FS Date: 5/15/2014

Headwall and flapgate on WS toe.

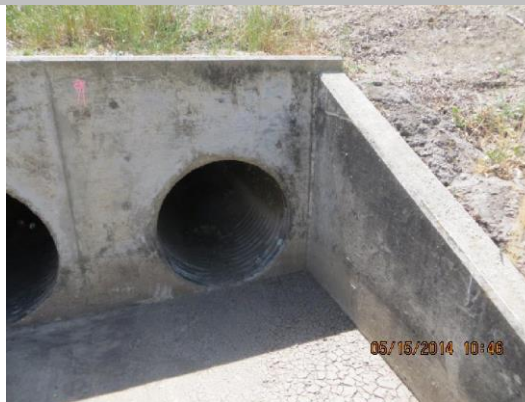
Photo 3 of 3 : UCIP_FA_2017_37957_69053.jpg

Headwall on LS toe.

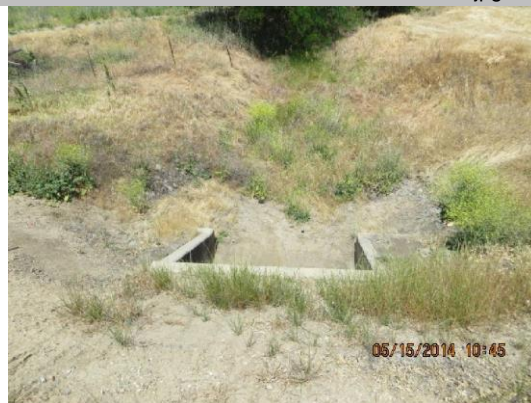
Photo 1 of 3 : UCIP_FA_2017_41807_69050.jpg

LM Start	4.97	Rating **	M	Issue No.	1082	
LM End	4.97	Issue Type +	Ma	Location *		
Category	Supplemental			GPS Latitude/Longitude		
				Start		End
Item	DWR UCIP LMA Responsibility			38.050700 °		38.050700 °
				-121.286552 °		-121.286552 °
DWR ID						
Comment Code						
Inspector Comment						
FS_ID:41807						
DS_ID:23678						
EP_NO: N/A						
Repair Type: Non-Urgent						
Crossing Status: Found						
UCIP Comments: Some silt buildup in pipe.						
FIELD_STRUCT_DESC: 2 of 2: 36-inch corrugated metal drainage pipe through the levee, 8.9 feet below the crown. Concrete U-shaped headwall on both ends. Flap gate on the waterside (WS) end. Grouted intake on the landside (LS). Cobble grouted spillway across the berm. [Additional Reference(s): DWR Levee Log, 1987. USACE San Joaquin O&M Manual 612.1, June 1965, (HLM 5.33)].						
FS Date: 5/15/2014

Concrete headwall on LS toe.

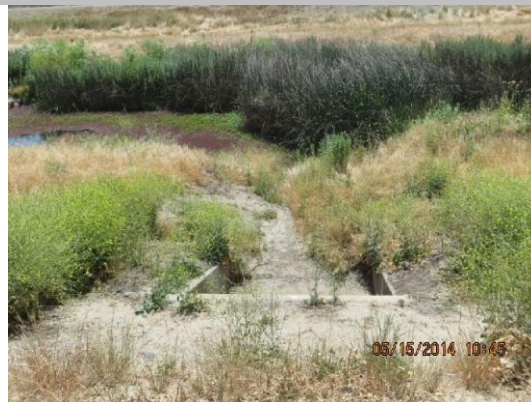
Photo 2 of 3 : UCIP_FA_2017_41807_69049.jpg

Headwall and flapgate on WS toe.

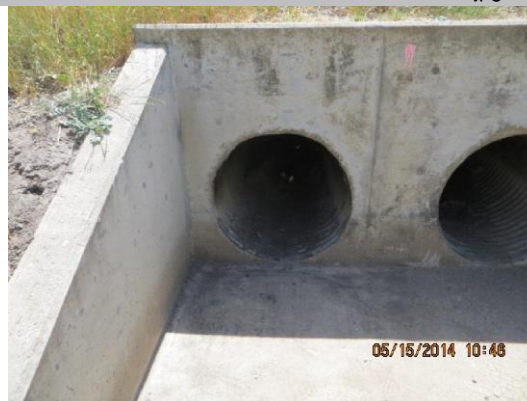
Photo 3 of 3 : UCIP_FA_2017_41807_69048.jpg

LM Start	4.97	Rating **	M	Issue No.	1082 (cont)	
LM End	4.97	Issue Type +	Ma	Location *		
Category	Supplemental			GPS Latitude/Longitude		
				Start		End
Item	DWR UCIP LMA Responsibility			38.050700 °		38.050700 °
				-121.286552 °		-121.286552 °
DWR ID						
Comment Code						
Inspector Comment						
FS_ID:41807						
DS_ID:23678						
EP_NO: N/A						
Repair Type: Non-Urgent						
Crossing Status: Found						
UCIP Comments: Some silt buildup in pipe.						
FIELD_STRUCT_DESC: 2 of 2: 36-inch corrugated metal drainage pipe through the levee, 8.9 feet below the crown. Concrete U-shaped headwall on both ends. Flap gate on the waterside (WS) end. Grouted intake on the landside (LS). Cobble grouted spillway across the berm. [Additional Reference(s): DWR Levee Log, 1987. USACE San Joaquin O&M Manual 612.1, June 1965, (HLM 5.33)].						
FS Date: 5/15/2014

Headwall at LS toe.

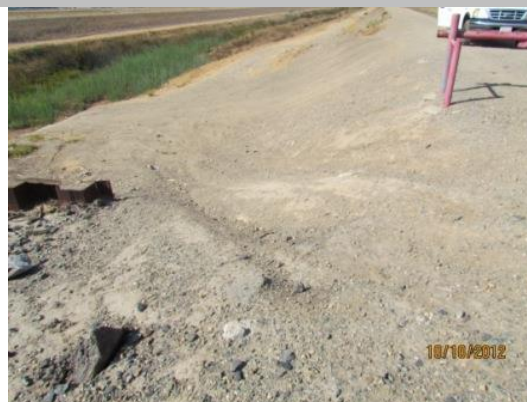
Photo 1 of 1 : FA_2017_NA0017_151_73_20170921_00025.jpg

LM Start	5.50	Rating **	M	Issue No.	73
LM End	5.50	Issue Type +	Ma	Location *	WS
Category	Earthen Levee			GPS Latitude/Longitude	
				Start	End
Item	Erosion / Bank Caving			38.052753 °	38.052753 °
				-121.277680 °	-121.277680 °
DWR ID	DWR_NA0017_07_f_2012_73				
Comment Code					
E2 : Schedule repair of erosion site prior to the next inspection.					
Inspector Comment					
Erosion caused by vehicle, and the slopes are stable.

Slope instability was found on the water side of the levee looking down stream.

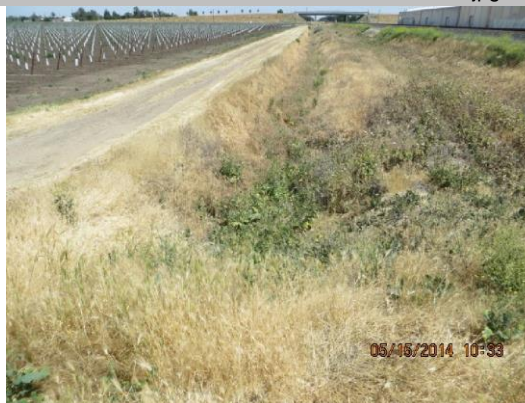
Photo 1 of 3 : UCIP_FA_2017_37885_68913.jpg

LM Start	5.50	Rating **	A/W	Issue No.	1083
LM End	5.50	Issue Type +	Ma	Location *	
Category	Supplemental			GPS Latitude/Longitude	
				Start	End
Item	DWR UCIP LMA Responsibility			38.052790 °	38.052790 °
				-121.277636 °	-121.277636 °
DWR ID					
Comment Code					
Inspector Comment					
FS_ID:37885 DS_ID:23544 EP_NO: N/A Repair Type: No Action Needed Crossing Status: Found UCIP Comments: FIELD_STRUCT_DESC: 36-inch corrugated metal storm drainage pipe through the levee, 10.6 feet below the crown. Concrete U-shaped headwall on the waterside (WS) end. Flap gate on the WS end. Cobble grouted spillway across the berm. [Additional Reference(s): DWR Levee Log, 1987. USACE San Joaquin O&M Manual 612.1, June 1965, (HLM 5.87) and 612 (addendum), February 1999, (HLM 5.81) (Station 306+88)]. FS Date: 5/15/2014

Pipe in channel on LS toe.

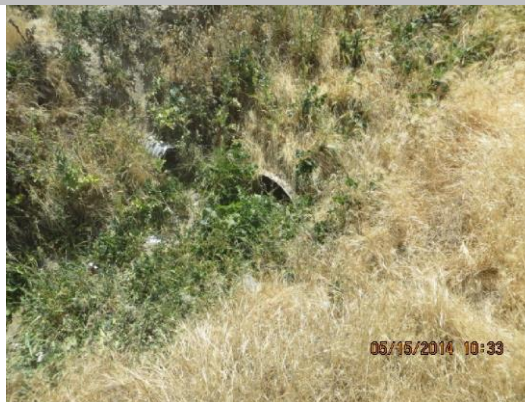
Photo 2 of 3 : UCIP_FA_2017_37885_68912.jpg

Pipe in channel on LS toe.

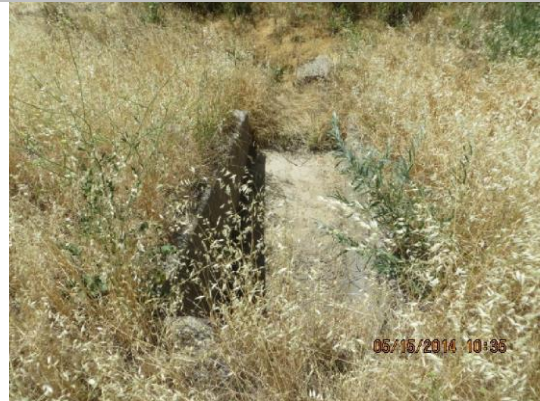
Photo 3 of 3 : UCIP_FA_2017_37885_68911.jpg

LM Start	5.50	Rating **	A/W	Issue No.	1083 (cont)
LM End	5.50	Issue Type +	Ma	Location *	
Category	Supplemental			GPS Latitude/Longitude	
				Start	End
Item	DWR UCIP LMA Responsibility			38.052790 °	38.052790 °
				-121.277636 °	-121.277636 °
DWR ID					
Comment Code					
Inspector Comment					
FS_ID:37885 DS_ID:23544 EP_NO: N/A Repair Type: No Action Needed Crossing Status: Found UCIP Comments: FIELD_STRUCT_DESC: 36-inch corrugated metal storm drainage pipe through the levee, 10.6 feet below the crown. Concrete U-shaped headwall on the waterside (WS) end. Flap gate on the WS end. Cobble grouted spillway across the berm. [Additional Reference(s): DWR Levee Log, 1987. USACE San Joaquin O&M Manual 612.1, June 1965, (HLM 5.87) and 612 (addendum), February 1999, (HLM 5.81) (Station 306+88)]. FS Date: 5/15/2014

Flapgate and headwall at WS toe.

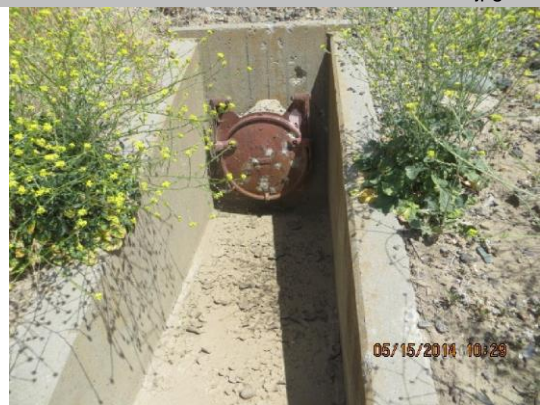
Photo 1 of 3 : UCIP_FA_2017_41801_68902.jpg

LM Start	5.52	Rating **	M	Issue No.	1085
LM End	5.52	Issue Type +	Ma	Location *	
Category	Supplemental			GPS Latitude/Longitude	
				Start	End
Item	DWR UCIP LMA Responsibility			38.052797 °	38.052797 °
				-121.277231 °	-121.277231 °
DWR ID					
Comment Code					
Inspector Comment					
FS_ID:41801					
DS_ID:23545					
EP_NO: N/A					
Repair Type: Non-Urgent					
Crossing Status: Found					
UCIP Comments: Some sediment buildup inside pipe.					
FIELD_STRUCT_DESC: 24-inch corrugated metal drainage pipe through the levee, 6.9 feet below the crown. Concrete U-shaped headwalls on both ends. Flap gate on the waterside (WS) end. Grouted intake on the landside (LS). Cobble grouted spillway across berm.					
[Additional Reference(s): DWR Levee Log, 1987. USACE San Joaquin O&M Manual 612.1, June 1965, (HLM 5.90)].					
FS Date: 5/15/2014

Headwall and flapgate on WS toe.

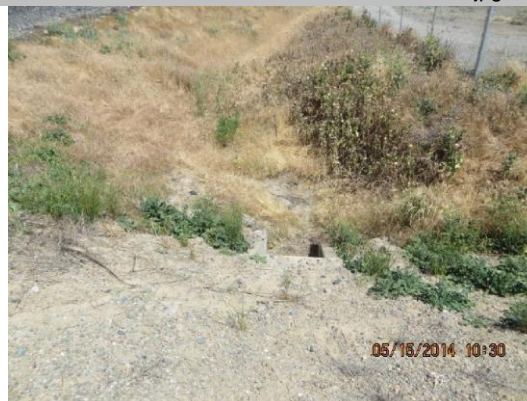
Photo 2 of 3 : UCIP_FA_2017_41801_68901.jpg

LM Start	5.52	Rating **	M	Issue No.	1085 (cont)	
LM End	5.52	Issue Type +	Ma	Location *		
Category	Supplemental			GPS Latitude/Longitude		
				Start		End
Item	DWR UCIP LMA Responsibility			38.052797 °		38.052797 °
				-121.277231 °		-121.277231 °
DWR ID						
Comment Code						
Inspector Comment						
FS_ID:41801 DS_ID:23545 EP_NO: N/A Repair Type: Non-Urgent Crossing Status: Found UCIP Comments: Some sediment buildup inside pipe. FIELD_STRUCT_DESC: 24-inch corrugated metal drainage pipe through the levee, 6.9 feet below the crown. Concrete U-shaped headwalls on both ends. Flap gate on the waterside (WS) end. Grouted intake on the landside (LS). Cobble grouted spillway across berm. [Additional Reference(s): DWR Levee Log, 1987. USACE San Joaquin O&M Manual 612.1, June 1965, (HLM 5.90)]. FS Date: 5/15/2014

Headwall on LS toe.

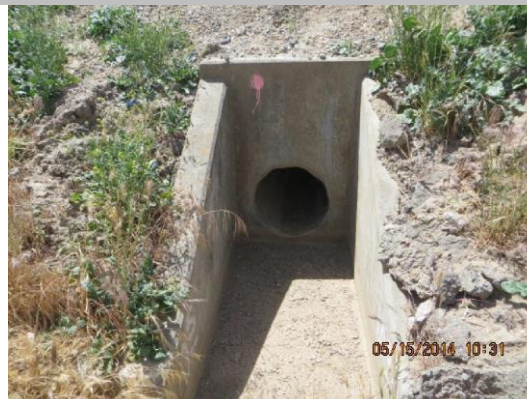
Photo 3 of 3 : UCIP_FA_2017_41801_68900.jpg

Headwall on LS toe.

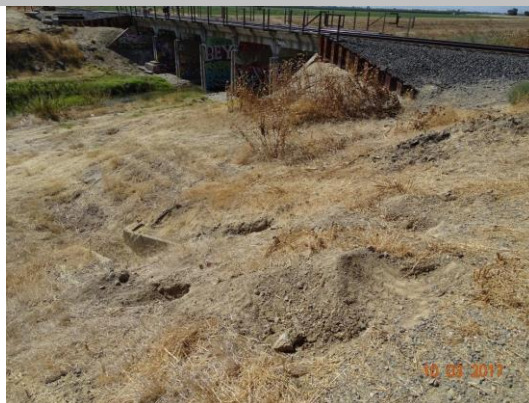
Photo 1 of 1 : FA_2017_NA0017_151_150_20171016_00553.jpg

LM Start	5.52	Rating **	M	Issue No.	150
LM End	5.52	Issue Type +	Ma	Location *	WS
Category	Earthen Levee			GPS Latitude/Longitude	
				Start	End
Item	Slope Stability			38.052758 °	38.052758 °
				-121.277215 °	-121.277215 °
DWR ID	DWR_NA0017_07_f_2017_150				
Comment Code					
S3 : Repair the levee slope damaged by vehicle traffic and prevent access where possible.					
Inspector Comment

View of a slope instability on the waterside slope of the levee looking downstream. Fall 2017

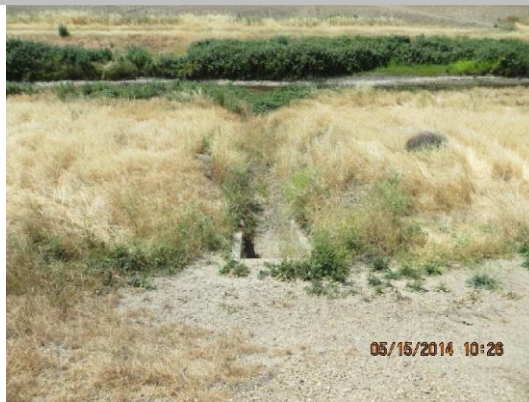
Photo 1 of 2 : UCIP_FA_2017_40213_68899.jpg

LM Start	5.60	Rating **	M	Issue No.	1086	
LM End	5.60	Issue Type +	Ma	Location *		
Category	Supplemental			GPS Latitude/Longitude		
				Start		End
Item	DWR UCIP LMA Responsibility			38.052793 °		38.052793 °
				-121.275858 °		-121.275858 °
DWR ID						
Comment Code						
Inspector Comment						
FS_ID:40213 DS_ID:23546 EP_NO: N/A Repair Type: Non-Urgent Crossing Status: Found UCIP Comments: Inlet burried at LS toe. Pipe may be abandoned and if so should be done so properly. FIELD_STRUCT_DESC: *ABANDONED* 36-inch corrugated metal drainage pipe through the levee, 7.9 feet below the crown. Concrete U-shaped headwall on the waterside (WS) end. Concrete headwall on the landside (LS). Flap gate on the WS end. Cobble grouted spillway across the berm. [Additional Reference(s): DWR Levee Log, 1987. USACE San Joaquin O&M Manual 612.1, June 1965, (HLM 5.97)]. FS Date: 5/15/2014

Headwall and flapgate at WS toe.

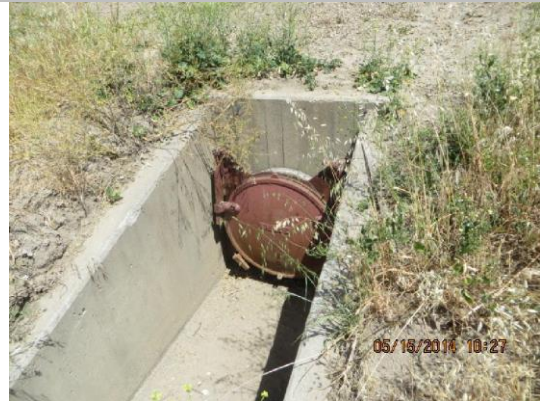
Photo 2 of 2 : UCIP_FA_2017_40213_68898.jpg

LM Start	5.60	Rating **	M	Issue No.	1086 (cont)
LM End	5.60	Issue Type +	Ma	Location *	
Category	Supplemental			GPS Latitude/Longitude	
				Start	End
Item	DWR UCIP LMA Responsibility			38.052793 °	38.052793 °
				-121.275858 °	-121.275858 °
DWR ID					
Comment Code					
Inspector Comment					
FS_ID:40213 DS_ID:23546 EP_NO: N/A Repair Type: Non-Urgent Crossing Status: Found UCIP Comments: Inlet burried at LS toe. Pipe may be abandoned and if so should be done so properly. FIELD_STRUCT_DESC: *ABANDONED* 36-inch corrugated metal drainage pipe through the levee, 7.9 feet below the crown. Concrete U-shaped headwall on the waterside (WS) end. Concrete headwall on the landside (LS). Flap gate on the WS end. Cobble grouted spillway across the berm. [Additional Reference(s): DWR Levee Log, 1987. USACE San Joaquin O&M Manual 612.1, June 1965, (HLM 5.97)]. FS Date: 5/15/2014

Headwall and flapgate at WS toe.

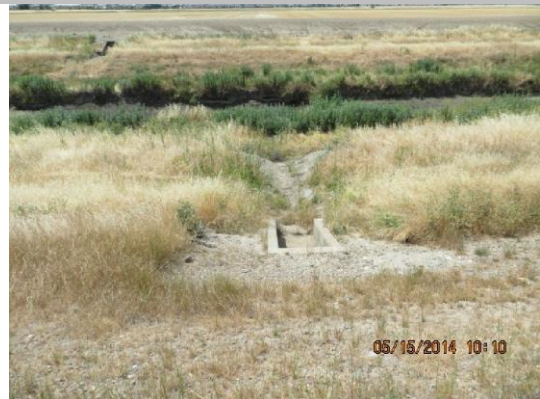
Photo 1 of 3 : UCIP_FA_2017_37874_68894.jpg

Headwall, flapgate, and grouted spillway on WS toe.

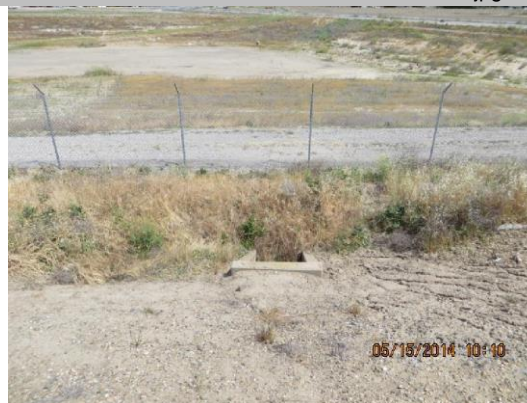
Photo 2 of 3 : UCIP_FA_2017_37874_68893.jpg

Headwall on LS toe.

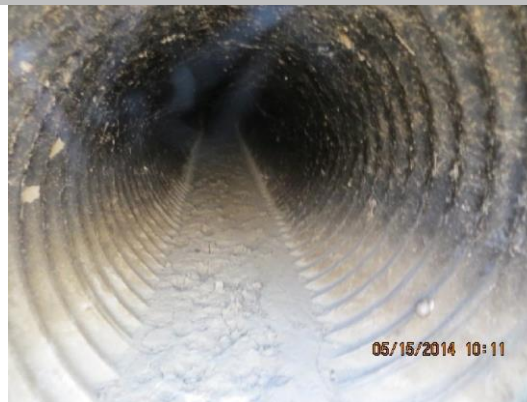
Photo 3 of 3 : UCIP_FA_2017_37874_68897.jpg

Inside pipe at LS toe. Note sediment buildup.

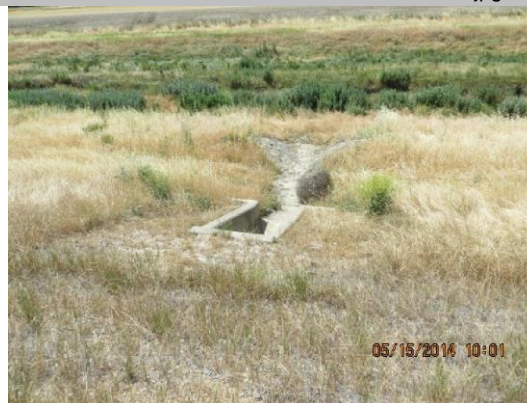
Photo 1 of 3 : UCIP_FA_2017_41802_68885.jpg

Comment Code						
Inspector Comment						
FS_ID:41802						
DS_ID:23551						
EP_NO: N/A						
Repair Type: Non-Urgent						
Crossing Status: Found						
UCIP Comments: Sediment buildup in pipe at LS toe.						
FIELD_STRUCT_DESC: 24-inch corrugated metal storm drainage pipe through the levee, 5.5 feet below the crown. Concrete U-shaped headwalls on both ends. Flap gate on the waterside (WS) end. Grouted intake on the landside (LS). Cobble grouted spillway across the berm. [Additional Reference(s): DWR Levee Log, 1987. USACE San Joaquin O&M Manual 612.1, June 1965, (HLM 6.32) and 612 (addendum), February 1999, (HLM 6.34) (Station 334+54), listed as a 36-inch pipe].						
FS Date: 5/15/2014

Headwall and flapgate on WS toe.

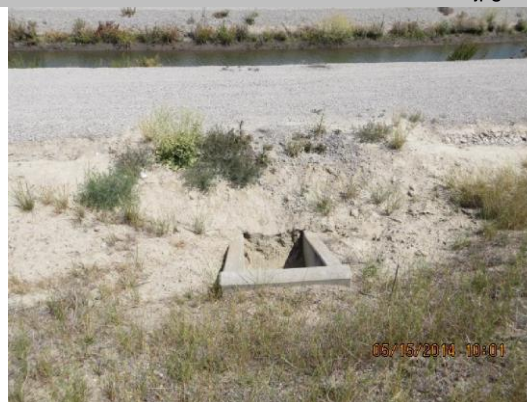
Photo 2 of 3 : UCIP_FA_2017_41802_68884.jpg

Headwall on LS toe.

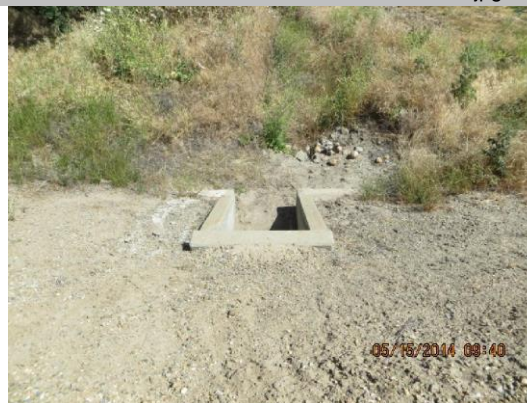
Photo 1 of 3 : UCIP_FA_2017_37852_68873.jpg

Headwall on LS toe.

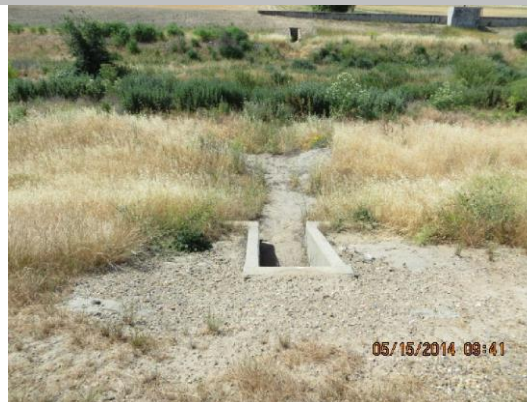
Photo 2 of 3 : UCIP_FA_2017_37852_68872.jpg

Headwall, flapgate, and grouted spillway on WS toe.

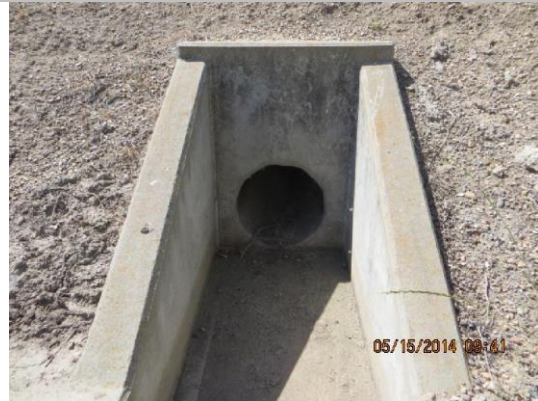
Photo 3 of 3 : UCIP_FA_2017_37852_68871.jpg

Headwall on LS toe.

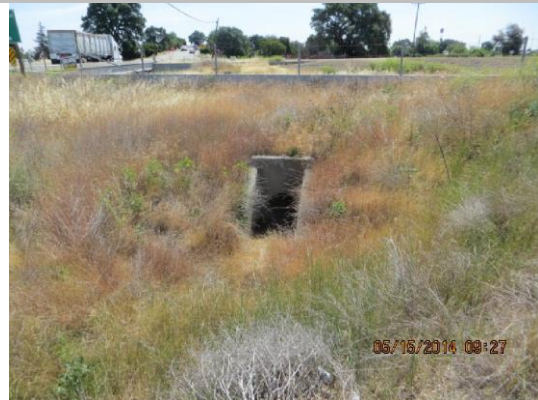
Photo 1 of 3 : UCIP_FA_2017_37849_68868.jpg

Pipe and headwall on LS toe.

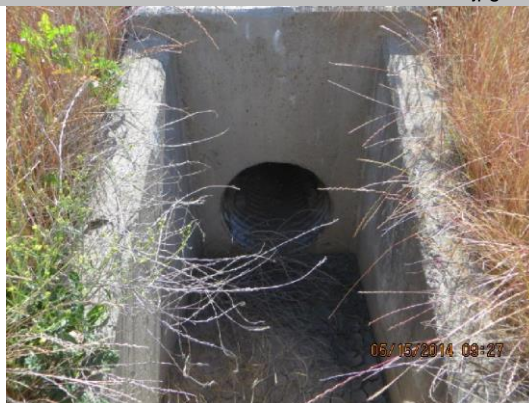
Photo 2 of 3 : UCIP_FA_2017_37849_68867.jpg

Pipe and headwall on LS toe.

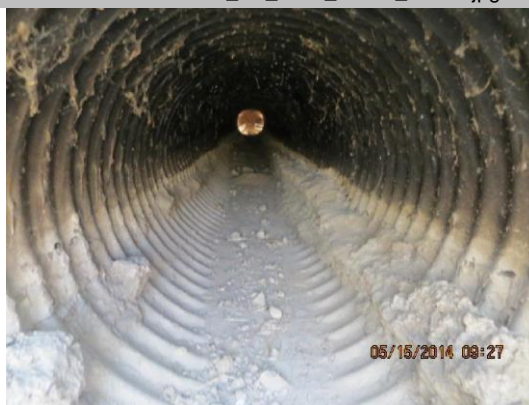
Photo 3 of 3 : UCIP_FA_2017_37849_68866.jpg

Inside pipe at LS toe.

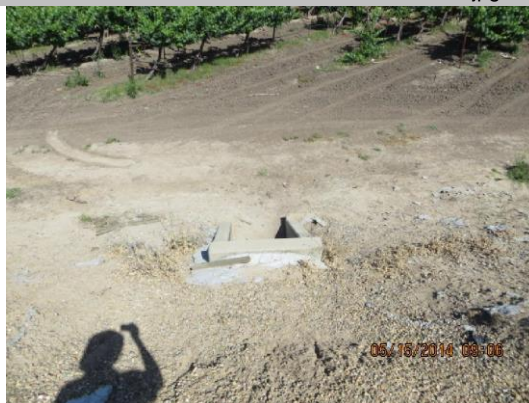
Photo 1 of 3 : UCIP_FA_2017_37847_68860.jpg

Pipe and headwall on LS toe.

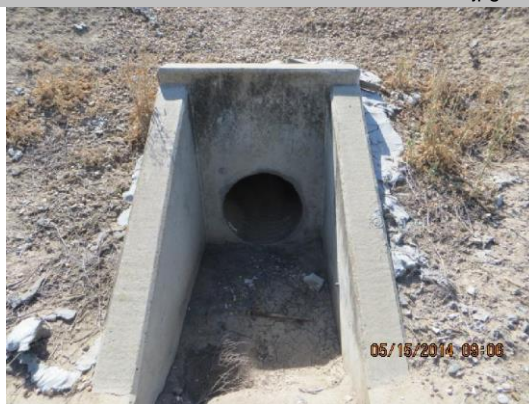
Photo 2 of 3 : UCIP_FA_2017_37847_68859.jpg

Pipe and headwall on LS toe.

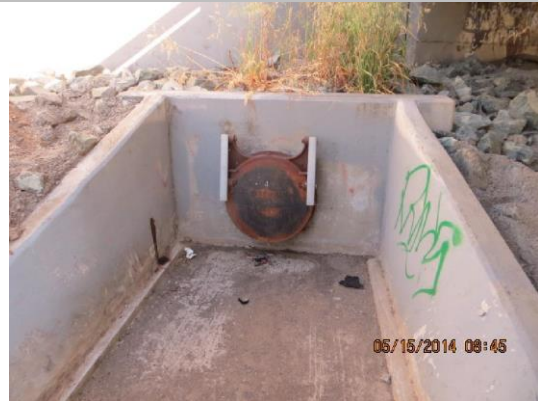
Photo 1 of 1 : UCIP_FA_2017_40534_68856.jpg

Pipe, flapgate, and headwall on WS toe.

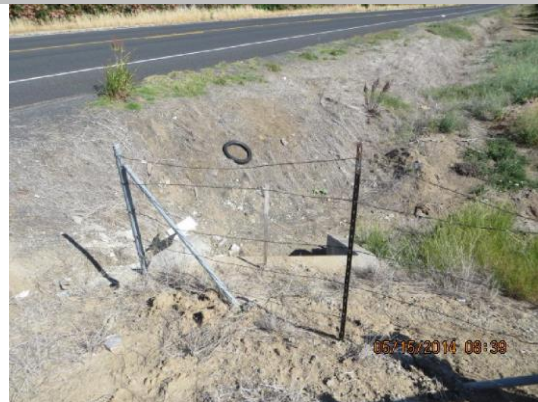
Photo 1 of 3 : UCIP_FA_2017_37844_68853.jpg

Pipe and headwall on LS toe.

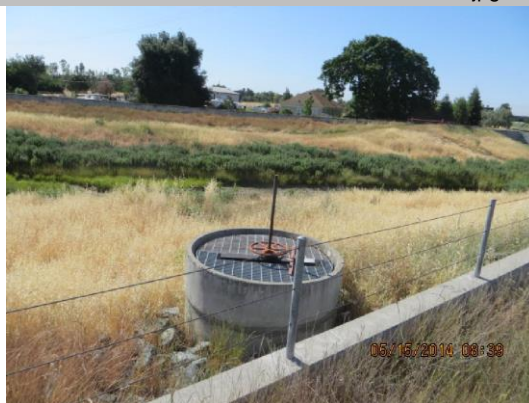
Photo 2 of 3 : UCIP_FA_2017_37844_68852.jpg

Slide gate in a 72-inch concrete riser on WS slope.

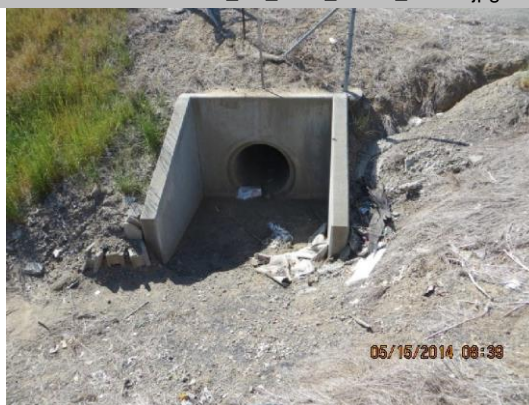
Photo 3 of 3 : UCIP_FA_2017_37844_68851.jpg

Pipe and headwall on LS toe.

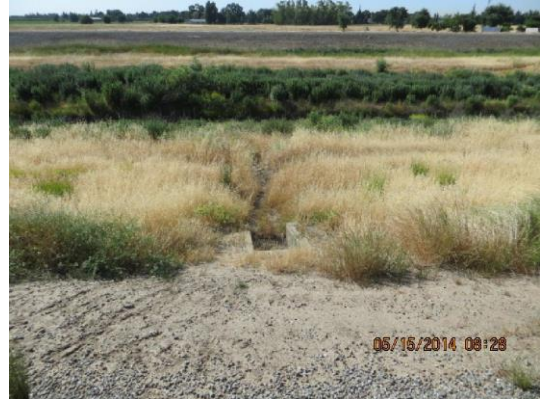
Photo 1 of 3 : UCIP_FA_2017_37842_68848.jpg

Headwall, pipe, flapgate, and grouted spillway on WS toe.

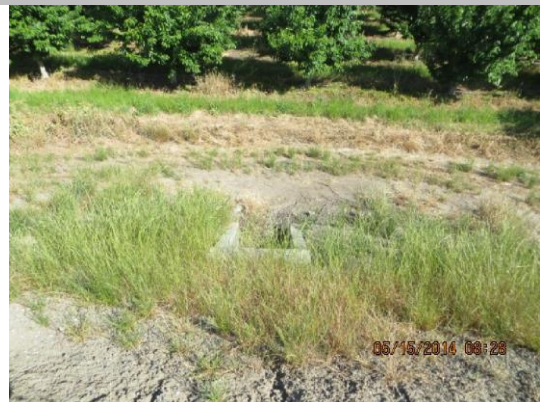
Photo 2 of 3 : UCIP_FA_2017_37842_68847.jpg

Pipe and headwall on LS toe.

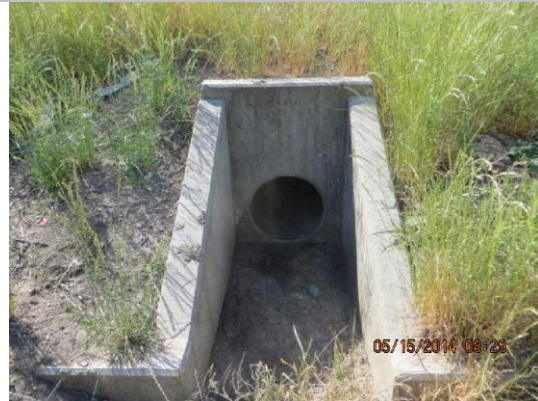
Photo 3 of 3 : UCIP_FA_2017_37842_68846.jpg

Pipe and headwall on LS toe.

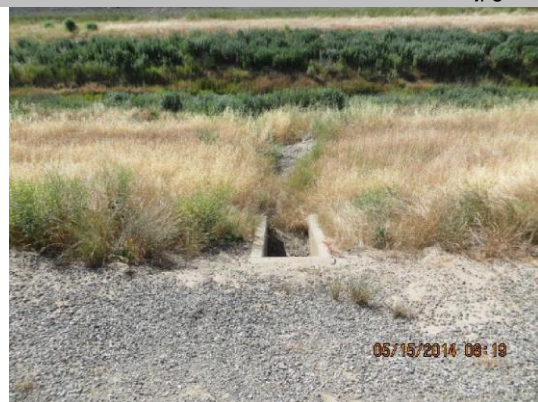
Photo 1 of 3 : UCIP_FA_2017_37841_68843.jpg

Pipe, headwall, flapgate, and grouted spillway on WS toe.

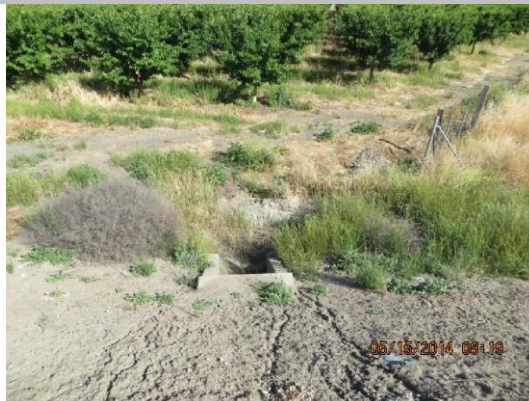
Photo 2 of 3 : UCIP_FA_2017_37841_68842.jpg

Pipe and headwall at LS toe.

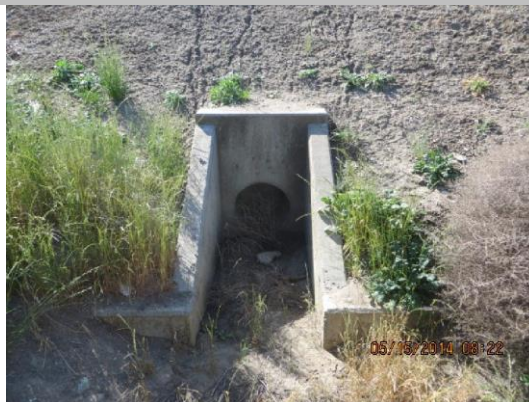
Photo 3 of 3 : UCIP_FA_2017_37841_68841.jpg

Pipe and headwall at LS toe.

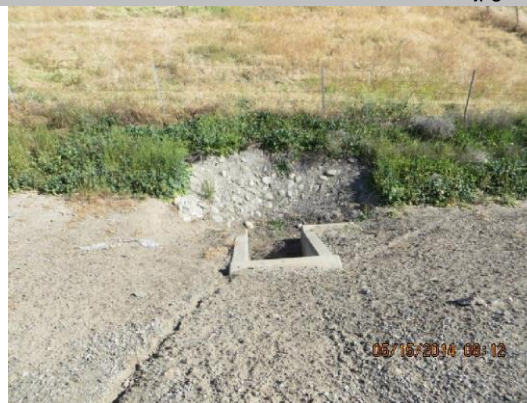
Photo 1 of 3 : UCIP_FA_2017_37840_68838.jpg

Pipe and headwall on LS toe.

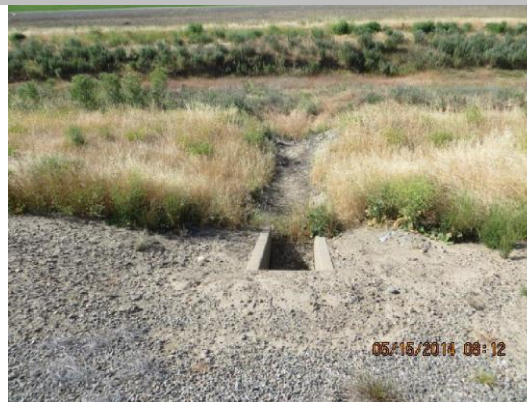
Photo 2 of 3 : UCIP_FA_2017_37840_68837.jpg

Pipe, headwall, flapgate, and grouted spillway on WS toe.

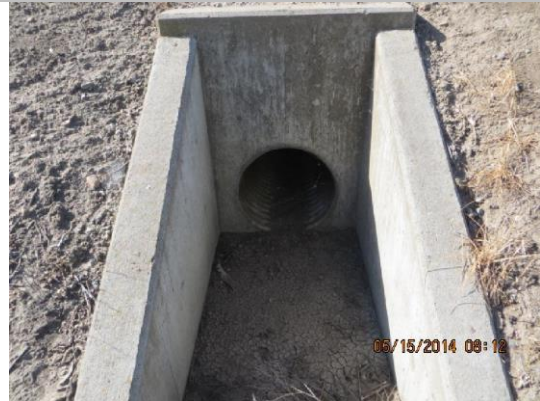
Photo 3 of 3 : UCIP_FA_2017_37840_68836.jpg

Pipe and headwall on LS toe.

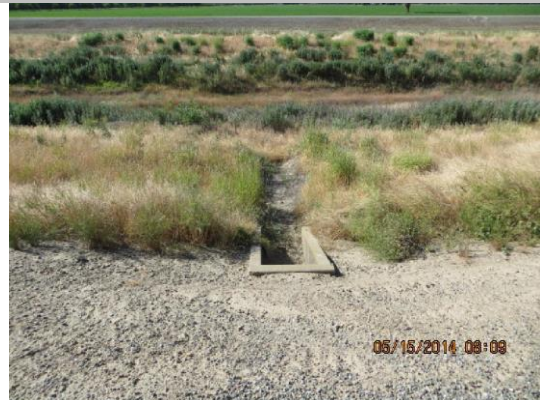
Photo 1 of 3 : UCIP_FA_2017_37839_68833.jpg

Pipe, headwall, flapgate, and grouted spillway on WS toe.

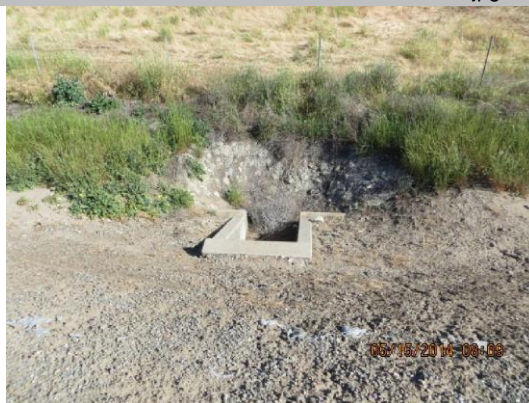
Photo 2 of 3 : UCIP_FA_2017_37839_68832.jpg

Pipe and headwall on LS toe.

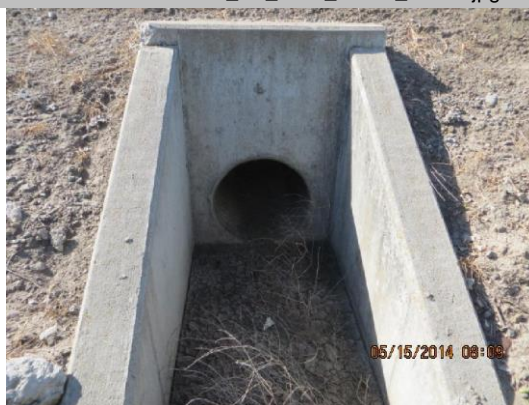
Photo 3 of 3 : UCIP_FA_2017_37839_68831.jpg

Pipe and headwall on LS toe.

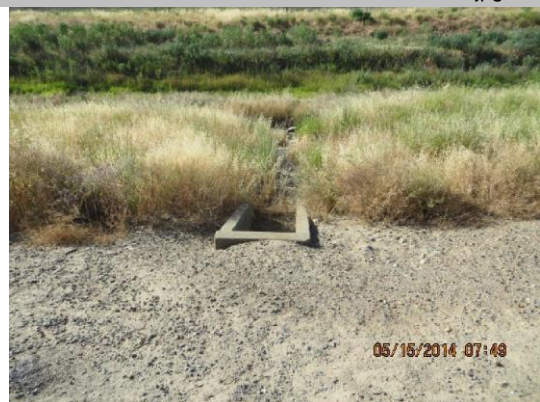
Photo 1 of 3 : UCIP_FA_2017_37837_68823.jpg

Pipe, flapgate, headwall, and grouted spillway on WS toe.

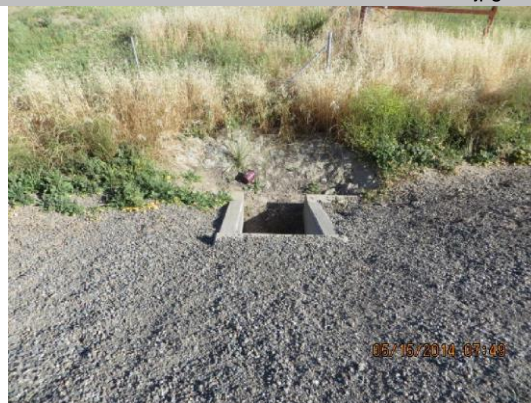
Photo 2 of 3 : UCIP_FA_2017_37837_68822.jpg

Pipe and headwall on LS toe.

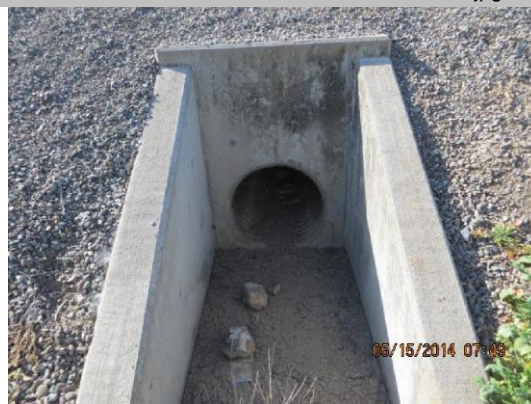
Photo 3 of 3 : UCIP_FA_2017_37837_68821.jpg

Pipe and headwall on LS toe.

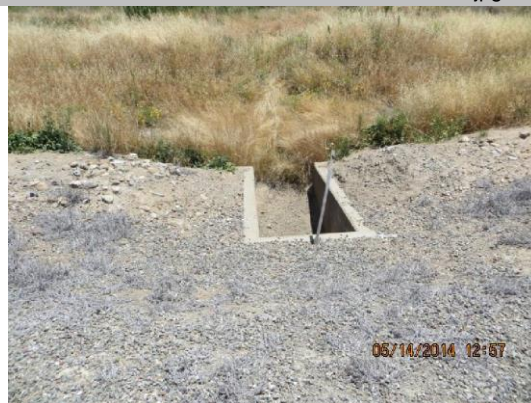
Photo 1 of 3 : UCIP_FA_2017_37835_68818.jpg

Pipe, flapgate, and headwall at WS toe.

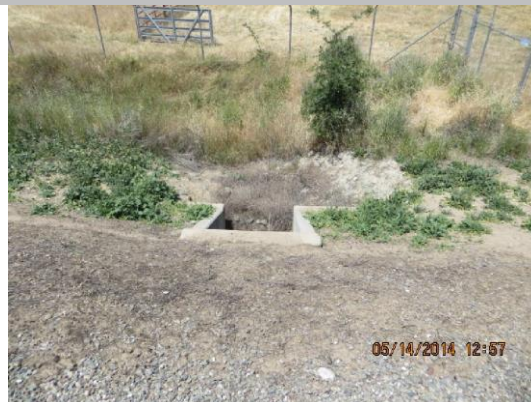
Photo 2 of 3 : UCIP_FA_2017_37835_68817.jpg

Pipe and headwall at LS toe.

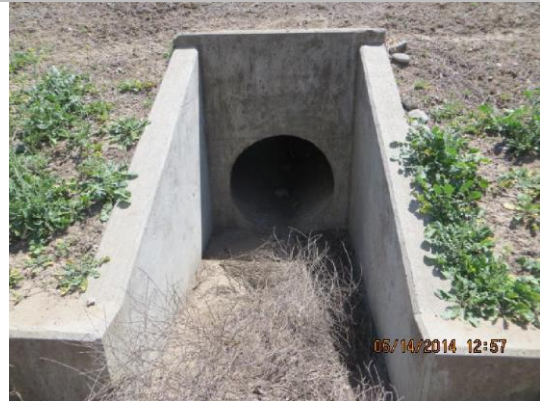
Photo 3 of 3 : UCIP_FA_2017_37835_68816.jpg

Pipe and headwall at LS toe.

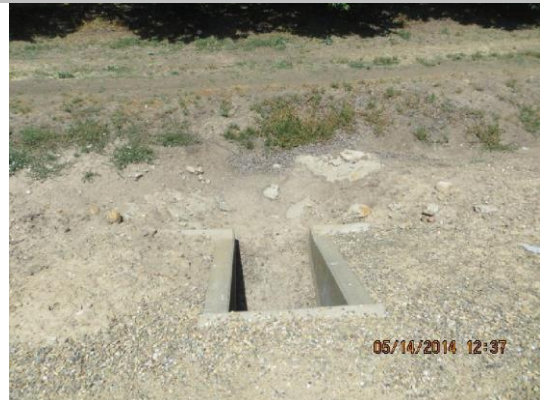
Photo 1 of 3 : UCIP_FA_2017_37830_68804.jpg

Pipe and headwall on LS toe.

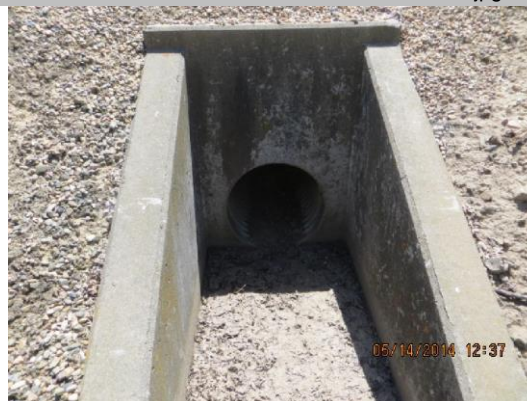
Photo 2 of 3 : UCIP_FA_2017_37830_68803.jpg

Pipe and headwall on LS toe.

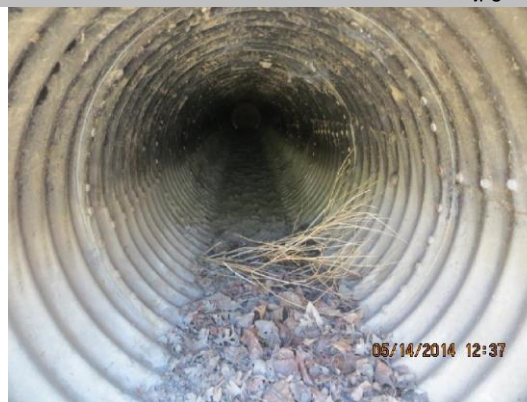
Photo 3 of 3 : UCIP_FA_2017_37830_68802.jpg

Inside pipe on LS toe.

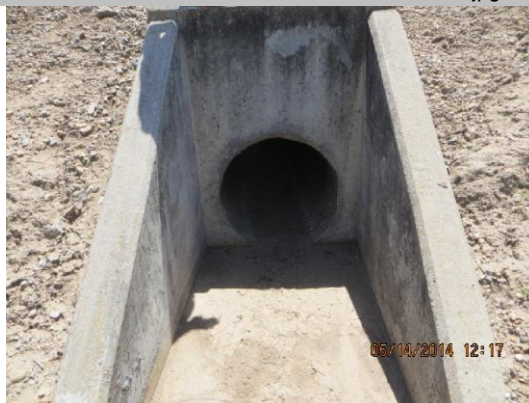
Photo 1 of 3 : UCIP_FA_2017_37826_68796.jpg

Pipe and headwall on LS toe.

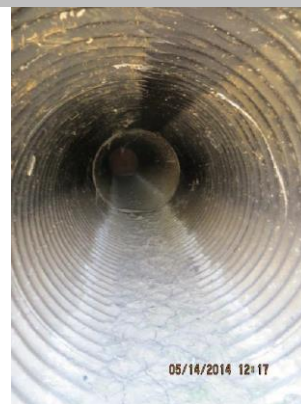
Photo 2 of 3 : UCIP_FA_2017_37826_68795.jpg

Comment Code						
Inspector Comment						
FS_ID:37826 DS_ID:23572 EP_NO: N/A Repair Type: Non-Urgent Crossing Status: Found UCIP Comments: A gap at the joint between pipe sections was noted inside pipe at LS toe. This may indicate a need for further maintenance. FIELD_STRUCT_DESC: 36-inch corrugated metal drainage pipe through the levee, 7 feet below the crown. Flap gate on the waterside (WS) end. Concrete U-shaped headwalls on both ends. Cobble grouted spillway across the berm. Cobble grouted apron on the landside (LS) end. [Additional Reference(s): DWR Levee Log, 1987. USACE San Joaquin O&M Manual 612.2, 1967, (HLM 8.77)]. FS Date: 5/14/2014

Inside pipe at LS toe. Note gap at joint between pipes.

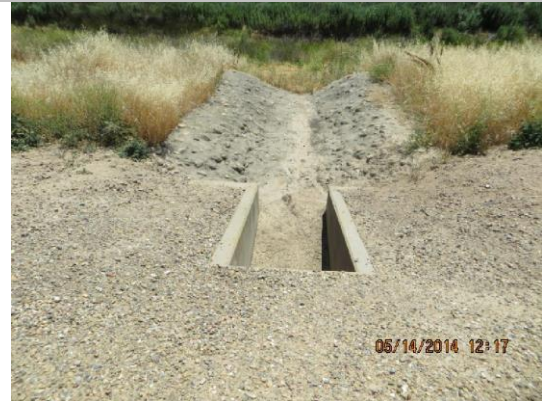
Photo 3 of 3 : UCIP_FA_2017_37826_68794.jpg

Headwall, pipe, flapgate, and grouted spillway on WS toe.

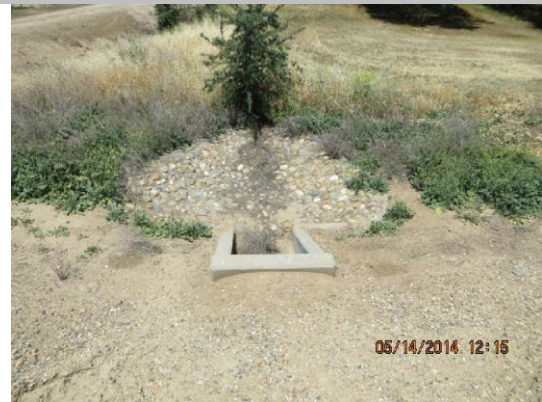
Photo 1 of 3 : UCIP_FA_2017_37825_68791.jpg

Comment Code					
Inspector Comment					
FS_ID:37825					
DS_ID:23573					
EP_NO: N/A					
Repair Type: Non-Urgent					
Crossing Status: Found					
UCIP Comments: Some gaps in Joints between pipe sections noted inside pipe on LS toe. May indicate a need for further maintenance.					
FIELD_STRUCT_DESC: 24-inch corrugated metal drainage pipe through the levee, 6.5 feet below the crown. Flap gate on the waterside (WS) end. Concrete U-shaped headwalls on both ends. Cobble grouted spillway across the berm. Cobble grouted apron on the landside (LS) end. [Additional Reference(s): DWR Levee Log, 1987. USACE San Joaquin O&M Manual 612.2, 1967, (HLM 8.78)].					
FS Date: 5/14/2014

Pipe and headwall on LS toe.

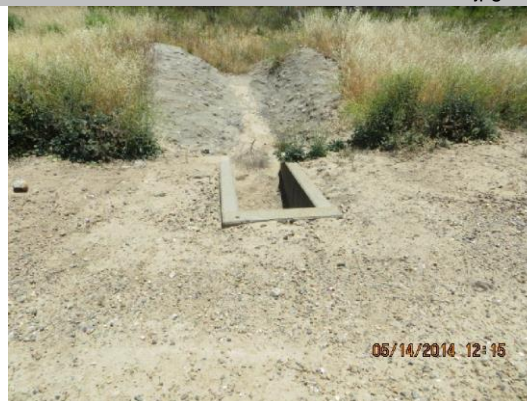
Photo 2 of 3 : UCIP_FA_2017_37825_68790.jpg

Pipe, headwall, flapgate, and grouted spillway on WS toe.

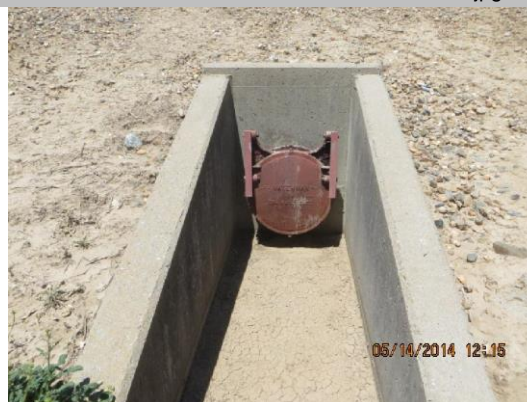
Photo 3 of 3 : UCIP_FA_2017_37825_68789.jpg

Pipe, headwall, and flapgate on WS toe.

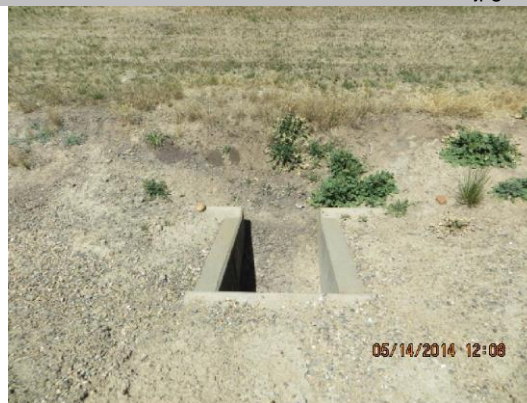
Photo 1 of 3 : UCIP_FA_2017_37818_68761.jpg

Pipe and headwall on LS toe.

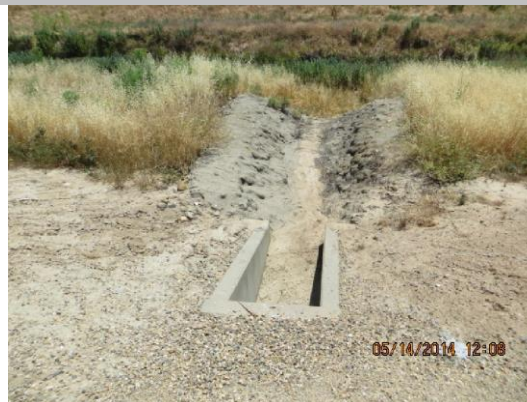
Photo 2 of 3 : UCIP_FA_2017_37818_68760.jpg

Pipe, flapgate, headwall, and grouted spillway on WS toe.

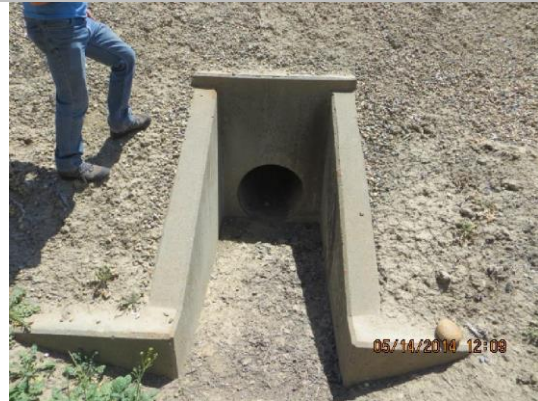
Photo 3 of 3 : UCIP_FA_2017_37818_68759.jpg

Pipe and headwall on LS toe.

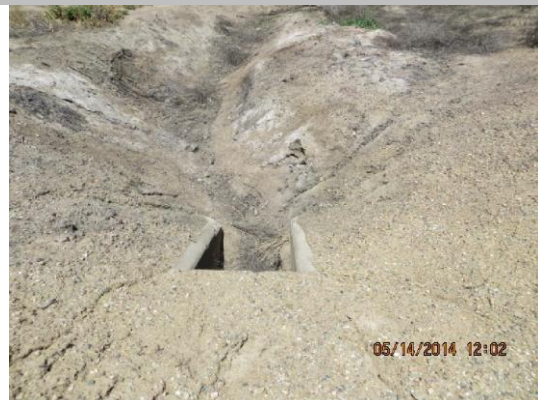
Photo 1 of 3 : UCIP_FA_2017_40206_68756.jpg

Pipe and headwall on LS toe.

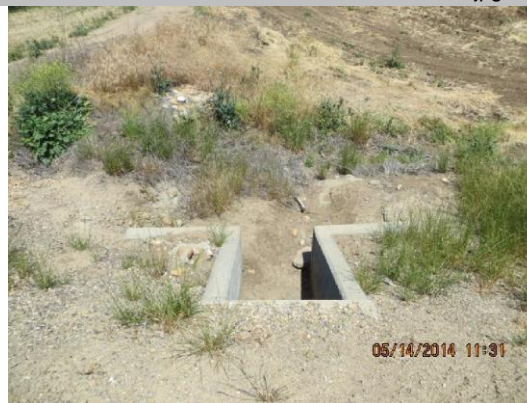
Photo 1 of 3 : UCIP_FA_2017_42951_68751.jpg

Pipe and headwall on LS toe.

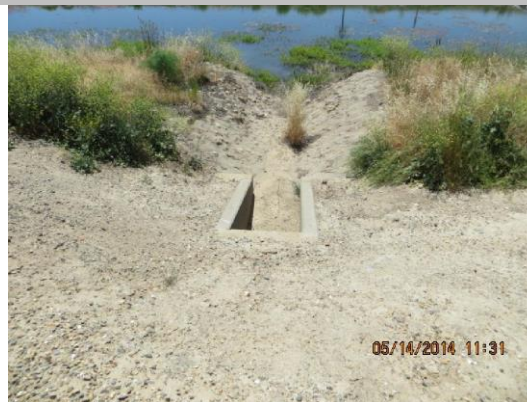
Photo 2 of 3 : UCIP_FA_2017_42951_68750.jpg

Headwall, pipe, flapgate, and grouted spillway on WS toe.

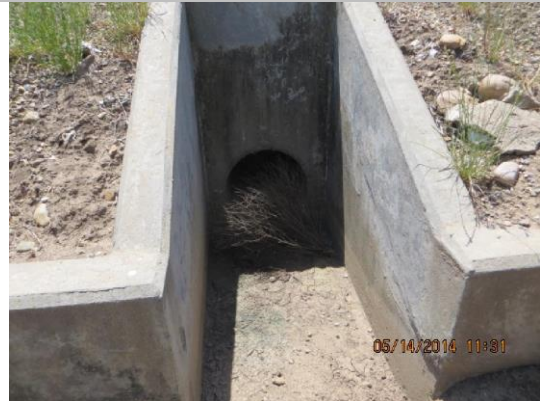
Photo 3 of 3 : UCIP_FA_2017_42951_68749.jpg

Pipe and headwall on LS toe.

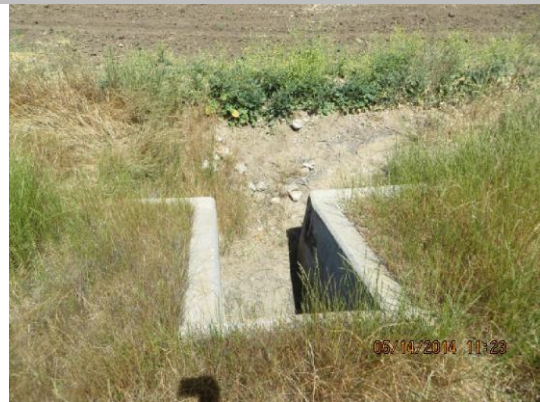
Photo 1 of 3 : UCIP_FA_2017_37813_68747.jpg

LM Start	9.11	Rating **	A/W	Issue No.	1113	
LM End	9.11	Issue Type +	Ma	Location *		
Category	Supplemental			GPS Latitude/Longitude		
				Start	End	
Item	DWR UCIP LMA Responsibility			38.070367 °	38.070367 °	
				-121.219932 °	-121.219932 °	
DWR ID						
Comment Code						
Inspector Comment						
FS_ID:37813						
DS_ID:23580						
EP_NO: N/A						
Repair Type: No Action Needed						
Crossing Status: Found						
UCIP Comments:						
FIELD_STRUCT_DESC: 24-inch corrugated metal storm drainage pipe through the levee, 6.5 feet below the crown. Flap gate on the waterside (WS) end. Concrete U-shaped headwall on both ends. Cobble grouted spillway and apron. [Additional Reference(s): DWR Levee Log, 1987. USACE San Joaquin O&M Manual 612.2, 1967, (HLM 9.56) and 612 (addendum), February 1999, (HLM 9.56) (Station 504+71)].						
FS Date: 5/14/2014

Headwall and pipe at LS toe.

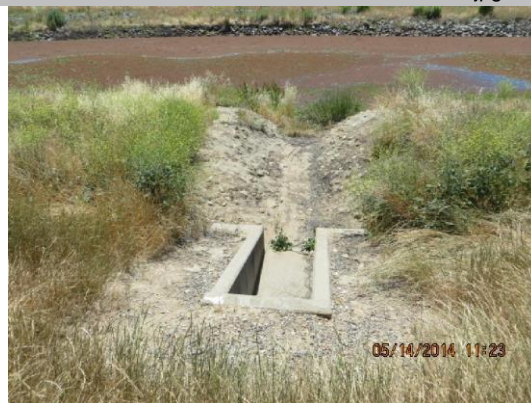
Photo 2 of 3 : UCIP_FA_2017_37813_68746.jpg

FS_ID:37813
DS_ID:23580
EP_NO: N/A
Repair Type: No Action Needed
Crossing Status: Found
UCIP Comments:
FIELD_STRUCT_DESC: 24-inch corrugated metal storm drainage pipe through the levee, 6.5 feet below the crown. Flap gate on the waterside (WS) end. Concrete U-shaped headwall on both ends. Cobble grouted spillway and apron. [Additional Reference(s): DWR Levee Log, 1987. USACE San Joaquin O&M Manual 612.2, 1967, (HLM 9.56) and 612 (addendum), February 1999, (HLM 9.56) (Station 504+71)].
FS Date: 5/14/2014

Headwall, pipe, flapgate, and grouted spillway on WS toe.

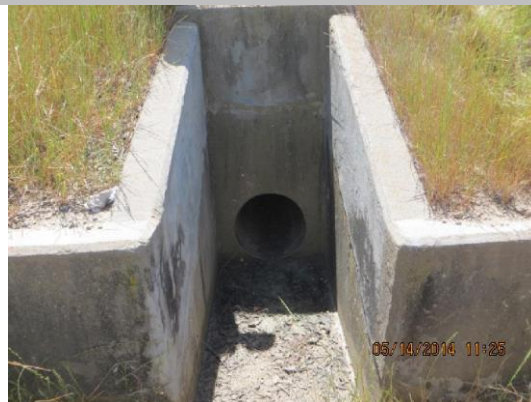
Photo 3 of 3 : UCIP_FA_2017_37813_68745.jpg

Headwall and pipe at LS toe.

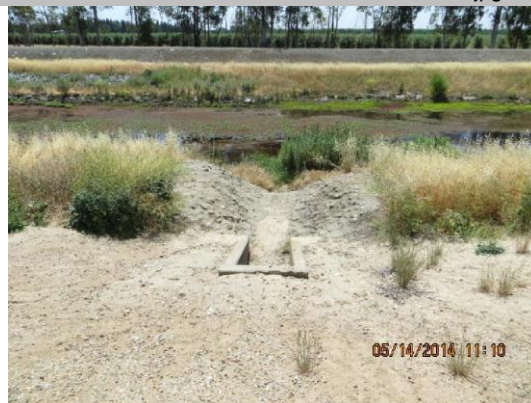
Photo 1 of 3 : UCIP_FA_2017_37810_68742.jpg

LM Start	9.45	Rating **	A/W	Issue No.	1114
LM End	9.45	Issue Type +	Ma	Location *	
Category	Supplemental			GPS Latitude/Longitude	
				Start	End
Item	DWR UCIP LMA Responsibility			38.073368 °	38.073368 °
				-121.215349 °	-121.215349 °
DWR ID					
Comment Code					
Inspector Comment					
FS_ID:37810					
DS_ID:23582					
EP_NO: N/A					
Repair Type: No Action Needed					
Crossing Status: Found					
UCIP Comments:					
FIELD_STRUCT_DESC: 24-inch corrugated metal drainage pipe through the levee, 7.5 feet below the crown. Flap gate on the waterside (WS) end. Concrete U-shaped headwalls on both ends. Cobble grouted spillway across the berm. Cobble grouted apron on the WS end.					
[Additional Reference(s): DWR Levee Log, 1987. USACE San Joaquin O&M Manual 612.2, 1967, (HLM 9.91)].					
FS Date: 5/14/2014

Headwall and flapgate on WS toe.

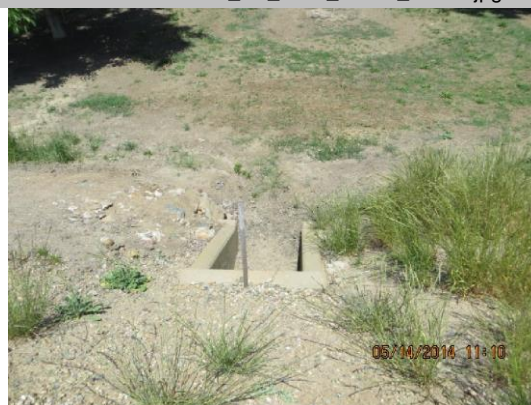
Photo 2 of 3 : UCIP_FA_2017_37810_68741.jpg

Pipe and headwall on LS toe.

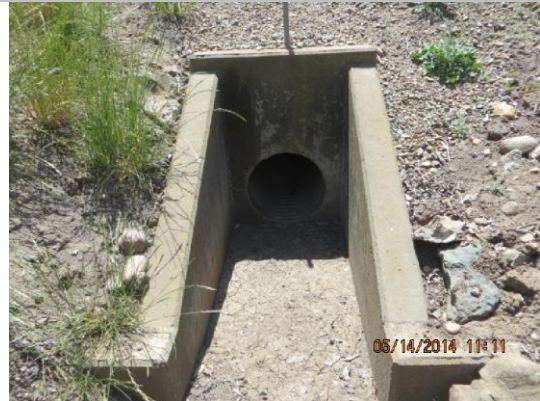
Photo 3 of 3 : UCIP_FA_2017_37810_68740.jpg

LM Start	9.45	Rating **	A/W	Issue No.	1114 (cont)	
LM End	9.45	Issue Type +	Ma	Location *		
Category	Supplemental			GPS Latitude/Longitude		
				Start	End	
Item	DWR UCIP LMA Responsibility			38.073368 °	38.073368 °	
				-121.215349 °	-121.215349 °	
DWR ID						
Comment Code						
Inspector Comment						
FS_ID:37810						
DS_ID:23582						
EP_NO: N/A						
Repair Type: No Action Needed						
Crossing Status: Found						
UCIP Comments:						
FIELD_STRUCT_DESC: 24-inch corrugated metal drainage pipe						
through the levee, 7.5 feet below the crown. Flap gate on the waterside						
(WS) end. Concrete U-shaped headwalls on both ends. Cobble grouted						
spillway across the berm. Cobble grouted apron on the WS end.						
[Additional Reference(s): DWR Levee Log, 1987. USACE San Joaquin						
O&M Manual 612.2, 1967, (HLM 9.91)].						
FS Date: 5/14/2014

Pipe and headwall on LS toe.
