**Flood Control Project Maintenance
Levee Inspections**

Maintenance Issue Types Only, Levee Inspection Report By Mile - Fall 2017

San Joaquin County Flood Control and Water Conservation District

Waterway	Bank	Unit Miles	Inspection Start/End	Inspector
Unit No. 01 Littlejohn Creek	Left	2.59	10/17/2017 10/17/2017	Pavel Kazi

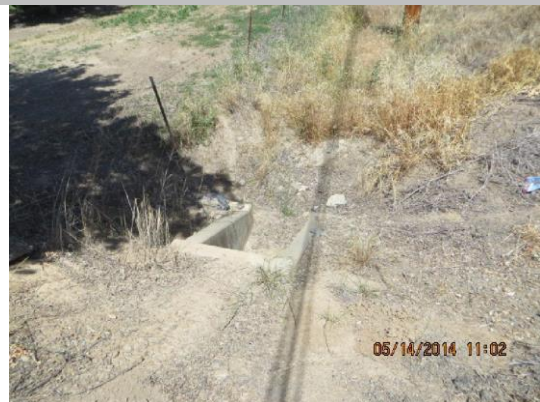
Photo 1 of 3 : UCIP_FA_2017_37809_68738.jpg

LM Start	9.63	Rating **	A/W	Issue No.	1115
LM End	9.63	Issue Type +	Ma	Location *	
Category	Supplemental			GPS Latitude/Longitude	
				Start	End
Item	DWR UCIP LMA Responsibility			38.074113 °	38.074113 °
				-121.212224 °	-121.212224 °
DWR ID					
Comment Code					
Inspector Comment					
FS_ID:37809 DS_ID:23583 EP_NO: N/A Repair Type: No Action Needed Crossing Status: Found UCIP Comments: FIELD_STRUCT_DESC: 24-inch corrugated metal storm drainage pipe through the levee, 10 feet below the crown. Flap gate on the waterside (WS) end. Concrete U-shaped headwalls on both ends. Cobble grouted spillway across the berm. Cobble grouted apron on the landside (LS) end. [Additional Reference(s): DWR Levee Log, 1987. USACE San Joaquin O&M Manual 612.2, 1967, (HLM 10.09) and 612 (addendum), February 1999, (HLM 9.94) (Station 524+90)]. FS Date: 5/14/2014

Concrete headwall and pipe on LS toe.

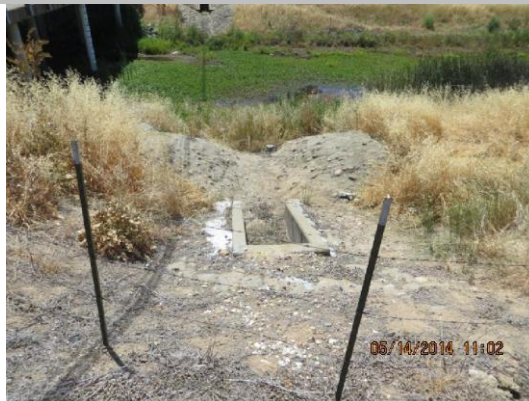
Photo 2 of 3 : UCIP_FA_2017_37809_68737.jpg

Item	DWR UCIP LMA Responsibility			38.074113 °		38.074113 °
				-121.212224 °		-121.212224 °
DWR ID						
Comment Code						
Inspector Comment						
FS_ID:37809						
DS_ID:23583						
EP_NO: N/A						
Repair Type: No Action Needed						
Crossing Status: Found						
UCIP Comments:						
FIELD_STRUCT_DESC: 24-inch corrugated metal storm drainage pipe through the levee, 10 feet below the crown. Flap gate on the waterside (WS) end. Concrete U-shaped headwalls on both ends. Cobble grouted spillway across the berm. Cobble grouted apron on the landside (LS) end. [Additional Reference(s): DWR Levee Log, 1987. USACE San Joaquin O&M Manual 612.2, 1967, (HLM 10.09) and 612 (addendum), February 1999, (HLM 9.94) (Station 524+90)].						
FS Date: 5/14/2014

Headwall, pipe, and flapgate on WS toe.

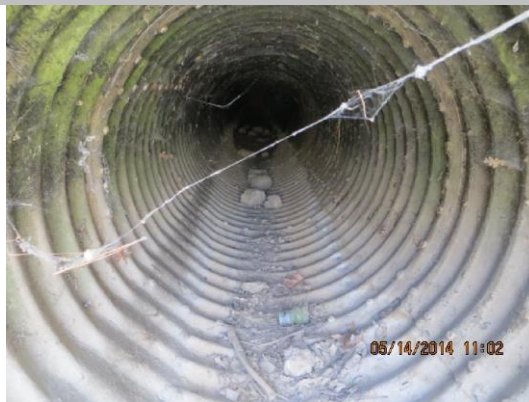
Photo 3 of 3 : UCIP_FA_2017_37809_68736.jpg

Inside pipe at LS toe.

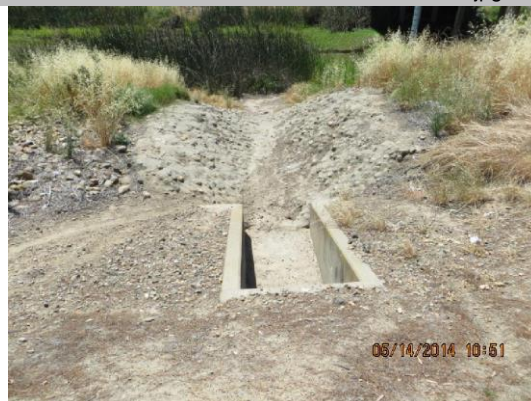
Photo 1 of 3 : UCIP_FA_2017_37807_68732.jpg

LM Start	9.65	Rating **	A/W	Issue No.	1116	
LM End	9.65	Issue Type +	Ma	Location *		
Category	Supplemental			GPS Latitude/Longitude		
				Start		End
Item	DWR UCIP LMA Responsibility			38.074201 °		38.074201 °
				-121.211920 °		-121.211920 °
DWR ID						
Comment Code						
Inspector Comment						
FS_ID:37807 DS_ID:23584 EP_NO: N/A Repair Type: No Action Needed Crossing Status: Found UCIP Comments: FIELD_STRUCT_DESC: 36-inch corrugated metal drainage pipe through the levee, 6 feet below the crown. Flap gate on the waterside (WS) end. Concrete U-shaped headwalls on both ends. Cobble grouted spillway across the berm. Cobble grouted apron on the landside (LS) end. [Additional Reference(s): DWR Levee Log, 1987. USACE San Joaquin O&M Manual 612.2, 1967, (HLM 10.11)]. FS Date: 5/14/2014

Headwall, pipe, flapgate, and grouted spillway on WS toe.

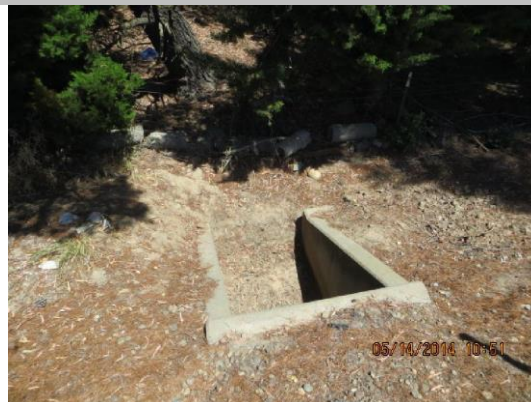
Photo 2 of 3 : UCIP_FA_2017_37807_68731.jpg

Pipe and headwall on LS toe.

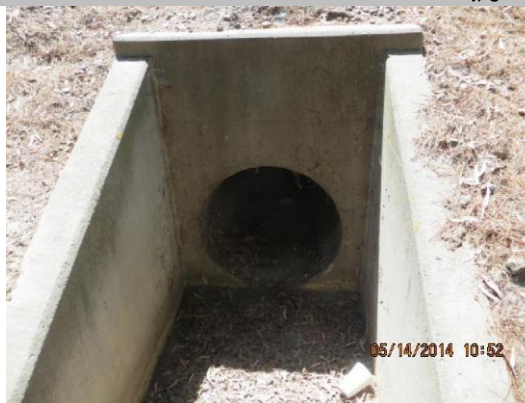
Photo 3 of 3 : UCIP_FA_2017_37807_68730.jpg

LM Start	9.65	Rating **	A/W	Issue No.	1116 (cont)	
LM End	9.65	Issue Type +	Ma	Location *		
Category	Supplemental			GPS Latitude/Longitude		
				Start		End
Item	DWR UCIP LMA Responsibility			38.074201 °	38.074201 °	
				-121.211920 °	-121.211920 °	
DWR ID						
Comment Code						
Inspector Comment						
FS_ID:37807 DS_ID:23584 EP_NO: N/A Repair Type: No Action Needed Crossing Status: Found UCIP Comments: FIELD_STRUCT_DESC: 36-inch corrugated metal drainage pipe through the levee, 6 feet below the crown. Flap gate on the waterside (WS) end. Concrete U-shaped headwalls on both ends. Cobble grouted spillway across the berm. Cobble grouted apron on the landside (LS) end. [Additional Reference(s): DWR Levee Log, 1987. USACE San Joaquin O&M Manual 612.2, 1967, (HLM 10.11)]. FS Date: 5/14/2014

Pipe and headwall on LS toe.

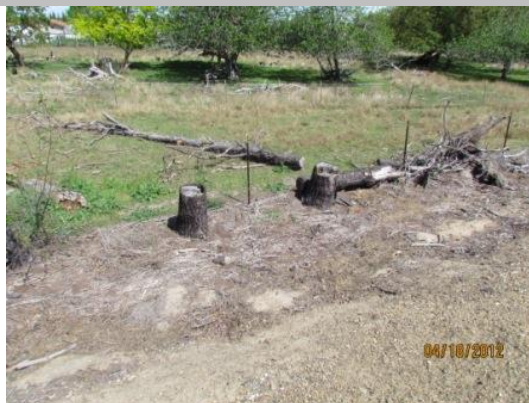
Photo 1 of 1 : FA_2017_NA0017_151_46_20170921_00015.jpg

LM Start	9.76	Rating **	N	Issue No.	46
LM End	9.76	Issue Type +	Ma	Location *	LS
Category	Earthen Levee			GPS Latitude/Longitude	
				Start	End
Item	Trim / Thin Trees			38.074613 °	38.074613 °
				-121.209882 °	-121.209882 °
DWR ID	DWR_NA0017_07_s_2012_46				
Comment Code					
T5 : Tree stumps.					
Inspector Comment

View of tree stumps found on the landside of the levee looking upstream.

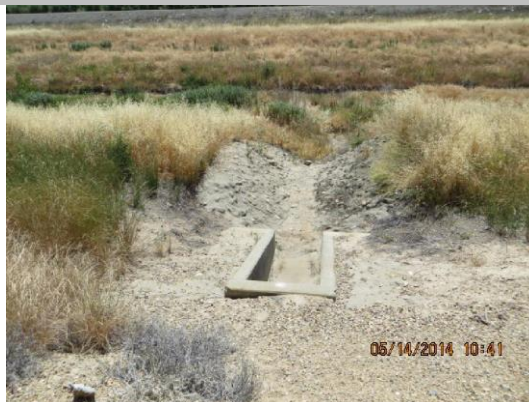
Photo 1 of 3 : UCIP_FA_2017_41804_68727.jpg

LM Start	9.98	Rating **	M	Issue No.	1117
LM End	9.98	Issue Type +	Ma	Location *	
Category	Supplemental			GPS Latitude/Longitude	
				Start	End
Item	DWR UCIP LMA Responsibility			38.077230 °	38.077230 °
				-121.208208 °	-121.208208 °
DWR ID					
Comment Code					
Inspector Comment					
FS_ID:41804 DS_ID:23585 EP_NO: N/A Repair Type: Non-Urgent Crossing Status: Found UCIP Comments: Some silt buildup in pipe. FIELD_STRUCT_DESC: 24-inch corrugated metal storm drainage pipe through the levee, 7.5 feet below the crown. Flap gate on the waterside (WS) end. Concrete U-shaped headwalls on both ends. Cobble grouted spillway across the berm. [Additional Reference(s): DWR Levee Log, 1987. USACE San Joaquin O&M Manual 612.2, 1967, (HLM 10.45) and 612 (addendum), February 1999, (HLM 10.46) (Station 552+25)]. FS Date: 5/14/2014

Headwall, pipe, flapgate, and grouted spillway on WS toe.

FS_ID:41804
DS_ID:23585
EP_NO: N/A
Repair Type: Non-Urgent
Crossing Status: Found
UCIP Comments: Some silt buildup in pipe.
FIELD_STRUCT_DESC: 24-inch corrugated metal storm drainage pipe through the levee, 7.5 feet below the crown. Flap gate on the waterside (WS) end. Concrete U-shaped headwalls on both ends. Cobble grouted spillway across the berm. [Additional Reference(s): DWR Levee Log, 1987. USACE San Joaquin O&M Manual 612.2, 1967, (HLM 10.45) and 612 (addendum), February 1999, (HLM 10.46) (Station 552+25)].
FS Date: 5/14/2014

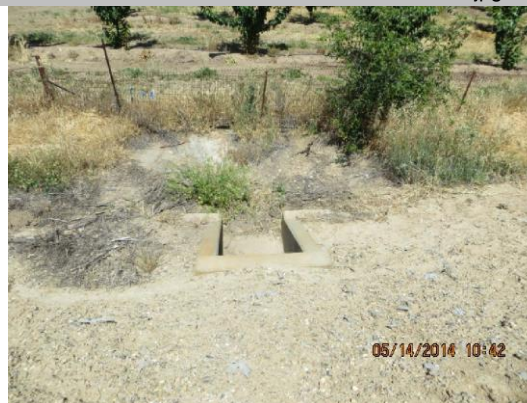
Photo 2 of 3 : UCIP_FA_2017_41804_68726.jpg

Pipe and headwall on LS toe.

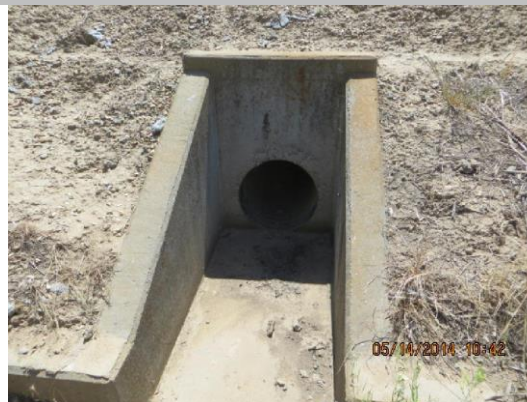
Photo 3 of 3 : UCIP_FA_2017_41804_68725.jpg

Pipe and headwall on LS toe.

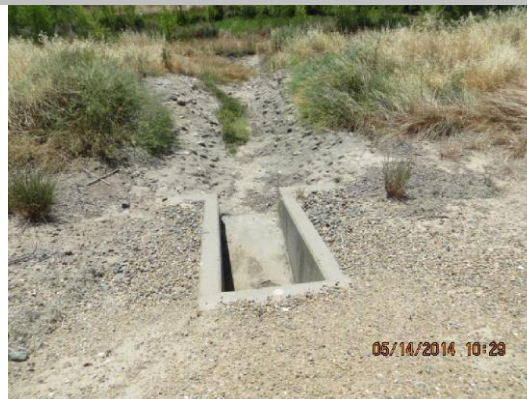
Photo 2 of 3 : UCIP_FA_2017_37803_68721.jpg

Headwall, pipe, flapgate, and grouted spillway on WS toe.

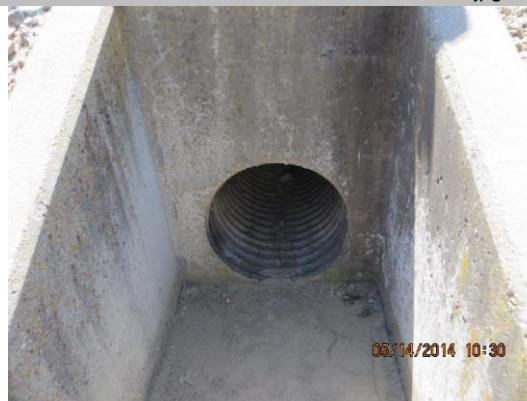
Photo 3 of 3 : UCIP_FA_2017_37803_68720.jpg

LM Start	10.15	Rating **	A/W	Issue No.	1118 (cont)	
LM End	10.15	Issue Type +	Ma	Location *		
Category	Supplemental			GPS Latitude/Longitude		
				Start	End	
Item	DWR UCIP LMA Responsibility			38.078814 °	38.078814 °	
				-121.205762 °	-121.205762 °	
DWR ID						
Comment Code						
Inspector Comment						
FS_ID:37803 DS_ID:23586 EP_NO: N/A Repair Type: No Action Needed Crossing Status: Found UCIP Comments: FIELD_STRUCT_DESC: 24-inch corrugated metal drainage pipe through the levee, 6 feet below the crown. Flap gate on the waterside (WS) end. Concrete U-shaped headwalls on both ends. Cobble grouted spillway across the berm. Cobble grouted apron on the landside (LS) end. [Additional Reference(s): USACE San Joaquin O&M Manual 612.2, 1967, (HLM 10.62)]. FS Date: 5/14/2014

Pipe and headwall on LS toe.

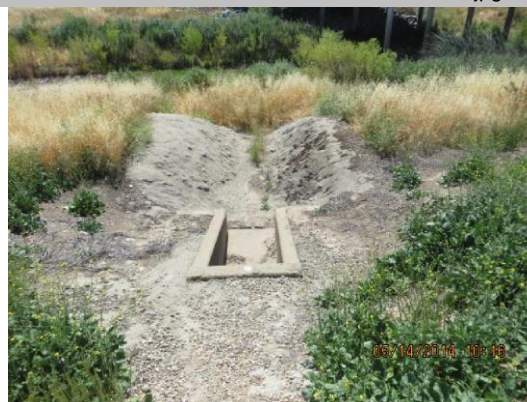
Photo 1 of 3 : UCIP_FA_2017_37786_68701.jpg

LM Start	10.43	Rating **	A/W	Issue No.	1119
LM End	10.43	Issue Type +	Ma	Location *	
Category	Supplemental			GPS Latitude/Longitude	
				Start	End
Item	DWR UCIP LMA Responsibility			38.080050 °	38.080050 °
				-121.201087 °	-121.201087 °
DWR ID					
Comment Code					
Inspector Comment					
FS_ID:37786 DS_ID:23646 EP_NO: N/A Repair Type: No Action Needed Crossing Status: Found UCIP Comments: FIELD_STRUCT_DESC: 24-inch corrugated metal storm drainage pipe through the levee, 7.5 feet below the crown. Flap gate on the waterside (WS). Concrete U-shaped headwall on both ends. [Additional Reference(s): DWR Levee Log, 1987. USACE San Joaquin O&M Manual 612.2, 1967, (HLM 10.91) and 612 (addendum), February 1999, (HLM 10.80) (Station 570+48)]. FS Date: 5/14/2014

Pipe, headwall, flapgate, and grouted spillway on WS slope.

FS_ID:37786
DS_ID:23646
EP_NO: N/A
Repair Type: No Action Needed
Crossing Status: Found
UCIP Comments:
FIELD_STRUCT_DESC: 24-inch corrugated metal storm drainage pipe through the levee, 7.5 feet below the crown. Flap gate on the waterside (WS). Concrete U-shaped headwall on both ends. [Additional Reference(s): DWR Levee Log, 1987. USACE San Joaquin O&M Manual 612.2, 1967, (HLM 10.91) and 612 (addendum), February 1999, (HLM 10.80) (Station 570+48)].
FS Date: 5/14/2014

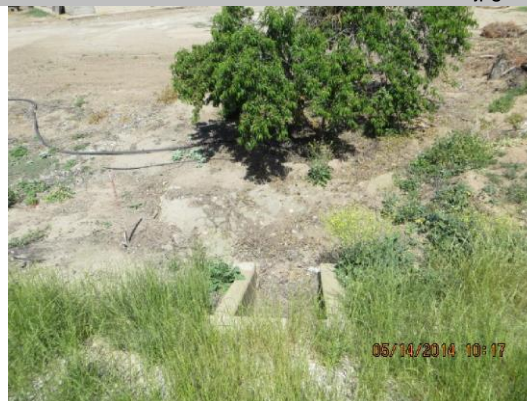
Photo 2 of 3 : UCIP_FA_2017_37786_68700.jpg

Pipe and headwall on LS toe.

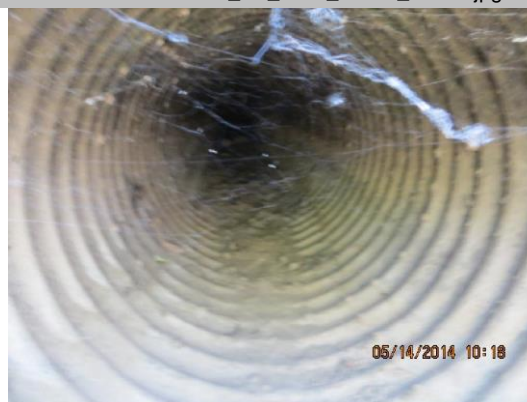
Photo 3 of 3 : UCIP_FA_2017_37786_68703.jpg

Inside pipe from LS toe.

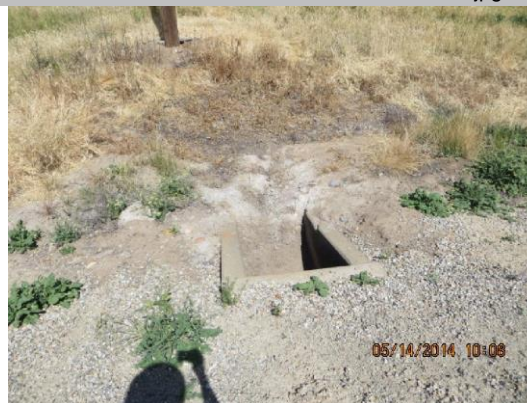
Photo 1 of 3 : UCIP_FA_2017_41805_68682.jpg

LM Start	10.65	Rating **	M	Issue No.	1120
LM End	10.65	Issue Type +	Ma	Location *	
Category	Supplemental			GPS Latitude/Longitude	
				Start	End
Item	DWR UCIP LMA Responsibility			38.082589 °	38.082589 °
				-121.198521 °	-121.198521 °
DWR ID					
Comment Code					
Inspector Comment					
FS_ID:41805					
DS_ID:23587					
EP_NO: N/A					
Repair Type: Non-Urgent					
Crossing Status: Found					
UCIP Comments: Silt buildup in pipe at LS toe.					
FIELD_STRUCT_DESC: 24-inch corrugated metal drainage pipe					
through the levee, 6.5 feet below the crown. Flap gate on the waterside					
(WS) end. Concrete U-shaped headwall on both ends. Cobble grouted					
spillway across the berm. Cobble grouted apron on the WS end.					
[Additional Reference(s): DWR Levee Log, 1987. USACE San Joaquin					
O&M Manual 612.2, 1967, (HLM 11.13)].					
FS Date: 5/14/2014

Pipe and headwall on LS toe.

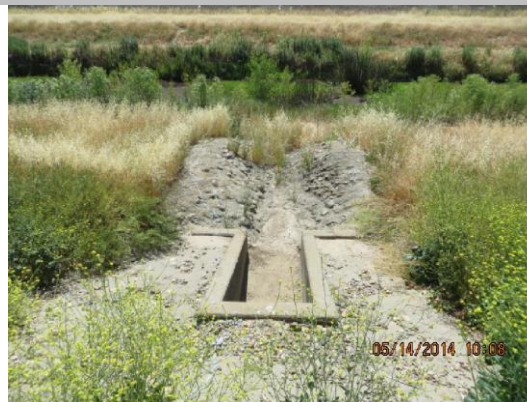
Photo 2 of 3 : UCIP_FA_2017_41805_68681.jpg

Pipe, flapgate, headwall, and grouted spillway on WS toe.

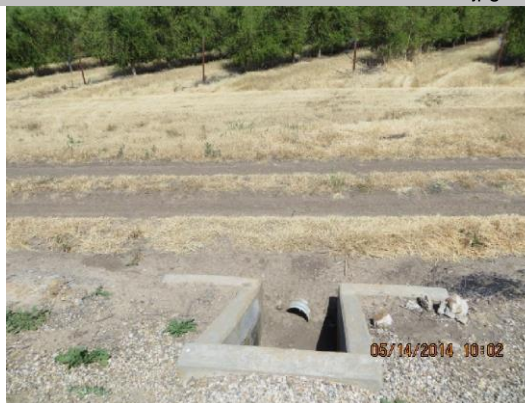
Photo 2 of 3 : UCIP_FA_2017_37779_68665.jpg

LM Start	10.81	Rating **	A/W	Issue No.	1121 (cont)	
LM End	10.81	Issue Type +	Ma	Location *		
Category	Supplemental			GPS Latitude/Longitude		
				Start	End	
Item	DWR UCIP LMA Responsibility			38.084165 °	38.084165 °	
				-121.196427 °	-121.196427 °	
DWR ID						
Comment Code						
Inspector Comment						
FS_ID:37779 DS_ID:23588 EP_NO: N/A Repair Type: No Action Needed Crossing Status: Found UCIP Comments: FIELD_STRUCT_DESC: 24-inch corrugated metal storm drainage pipe through the levee, 6.5 feet below the crown. Flap gate on the waterside (WS) end. Concrete U-shaped headwalls on both ends. Cobble grouted spillway across the berm. Cobble grouted apron on the landside (LS) end. [Additional Reference(s): DWR Levee Log, 1987. USACE San Joaquin O&M Manual 612.2, 1967, (HLM 11.30) and 612 (addendum), February 1999, (HLM 11.26) (Station 594+46)]. FS Date: 5/14/2014

Pipe and headwall on LS toe.

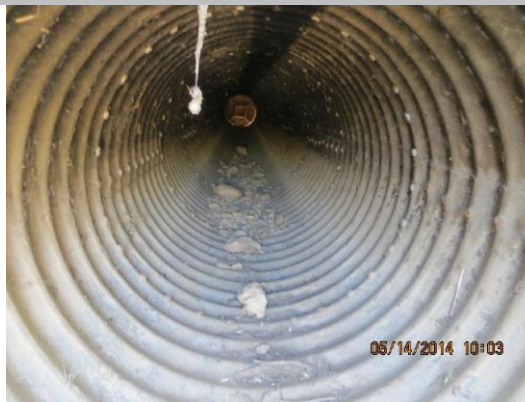
Photo 3 of 3 : UCIP_FA_2017_37779_68659.jpg

Inside pipe at LS toe.

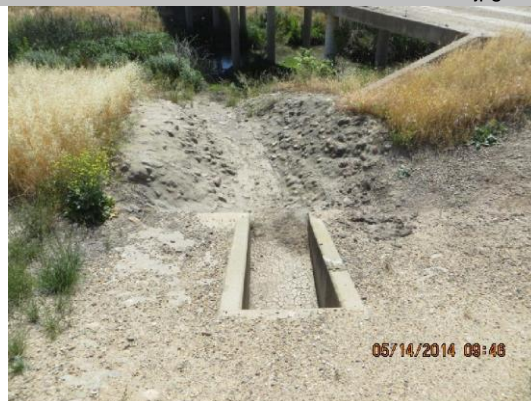
Photo 1 of 3 : UCIP_FA_2017_37773_68635.jpg

LM Start	11.27	Rating **	A/W	Issue No.	1122
LM End	11.27	Issue Type +	Ma	Location *	
Category	Supplemental			GPS Latitude/Longitude	
				Start	End
Item	DWR UCIP LMA Responsibility			38.087249 °	38.087249 °
				-121.189337 °	-121.189337 °
DWR ID					
Comment Code					
Inspector Comment					
FS_ID:37773 DS_ID:23590 EP_NO: N/A Repair Type: No Action Needed Crossing Status: Found UCIP Comments: FIELD_STRUCT_DESC: 24-inch corrugated metal drainage pipe through the levee, 7.5 feet below the crown. Flap gate on the waterside (WS) end. Concrete U-shaped headwalls on both ends. Cobble grouted spillway across the berm. Cobble grouted apron on the landside (LS) end. [Additional Reference(s): DWR Levee Log, 1987. USACE San Joaquin O&M Manual 612.2, 1967, (HLM 11.78)]. FS Date: 5/14/2014

Headwall, pipe, flapgate, and grouted spillway on WS slope.

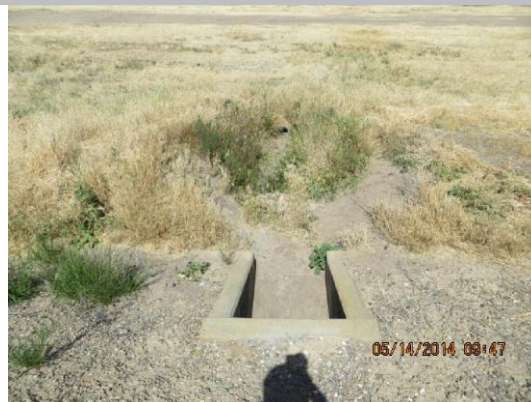
Photo 2 of 3 : UCIP_FA_2017_37773_68634.jpg

Pipe and headwall on LS toe.

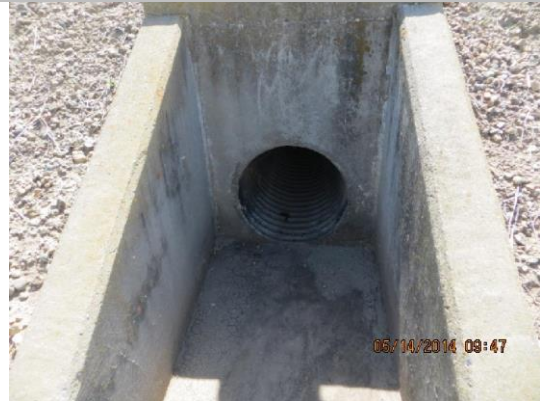
Photo 3 of 3 : UCIP_FA_2017_37773_68633.jpg

LM Start	11.27	Rating **	A/W	Issue No.	1122 (cont)	
LM End	11.27	Issue Type +	Ma	Location *		
Category	Supplemental			GPS Latitude/Longitude		
				Start	End	
Item	DWR UCIP LMA Responsibility			38.087249 °	38.087249 °	
				-121.189337 °	-121.189337 °	
DWR ID						
Comment Code						
Inspector Comment						
FS_ID:37773						
DS_ID:23590						
EP_NO: N/A						
Repair Type: No Action Needed						
Crossing Status: Found						
UCIP Comments:						
FIELD_STRUCT_DESC: 24-inch corrugated metal drainage pipe through the levee, 7.5 feet below the crown. Flap gate on the waterside (WS) end. Concrete U-shaped headwalls on both ends. Cobble grouted spillway across the berm. Cobble grouted apron on the landside (LS) end. [Additional Reference(s): DWR Levee Log, 1987. USACE San Joaquin O&M Manual 612.2, 1967, (HLM 11.78)].						
FS Date: 5/14/2014

Pipe and headwall on LS toe.

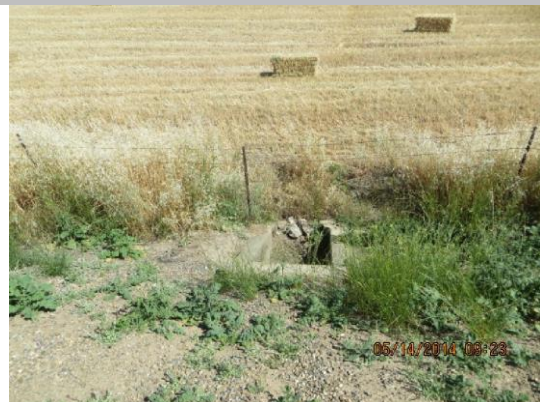
Photo 1 of 3 : UCIP_FA_2017_37753_68594.jpg

LM Start	11.79	Rating **	M	Issue No.	1124
LM End	11.79	Issue Type +	Ma	Location *	
Category	Supplemental			GPS Latitude/Longitude	
				Start	End
Item	DWR UCIP LMA Responsibility			38.092076 °	38.092076 °
				-121.183118 °	-121.183118 °
DWR ID					
Comment Code					
Inspector Comment					
FS_ID:37753 DS_ID:23593 EP_NO: N/A Repair Type: Non-Urgent Crossing Status: Found UCIP Comments: Some rocky debris buildup inside pipe on LS toe. FIELD_STRUCT_DESC: 24-inch corrugated metal drainage pipe through the levee, 8.5 feet below the crown. Flap gate on the waterside (WS) end. Concrete U-shaped headwalls on both ends. Cobble grouted spillway across the berm. Cobble grouted apron on the landside (LS) end. [Additional Reference(s): DWR Levee Log, 1987. USACE San Joaquin O&M Manual 612.2, 1967, (HLM 12.30)]. FS Date: 5/14/2014

Pipe and headwall on LS toe.

FS_ID:37753
DS_ID:23593
EP_NO: N/A
Repair Type: Non-Urgent
Crossing Status: Found
UCIP Comments: Some rocky debris buildup inside pipe on LS toe.
FIELD_STRUCT_DESC: 24-inch corrugated metal drainage pipe through the levee, 8.5 feet below the crown. Flap gate on the waterside (WS) end. Concrete U-shaped headwalls on both ends. Cobble grouted spillway across the berm. Cobble grouted apron on the landside (LS) end. [Additional Reference(s): DWR Levee Log, 1987. USACE San Joaquin O&M Manual 612.2, 1967, (HLM 12.30)].
FS Date: 5/14/2014

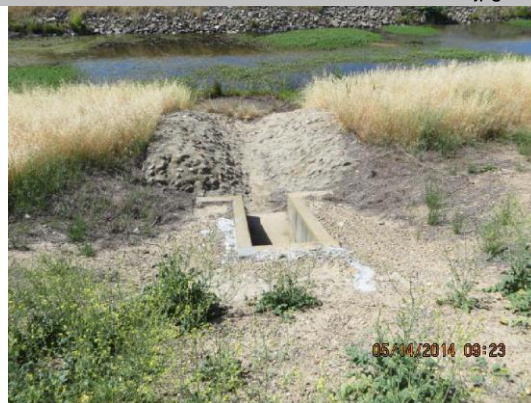
Photo 2 of 3 : UCIP_FA_2017_37753_68593.jpg

Pipe, flapgate, headwall, and grouted spillway on WS toe.

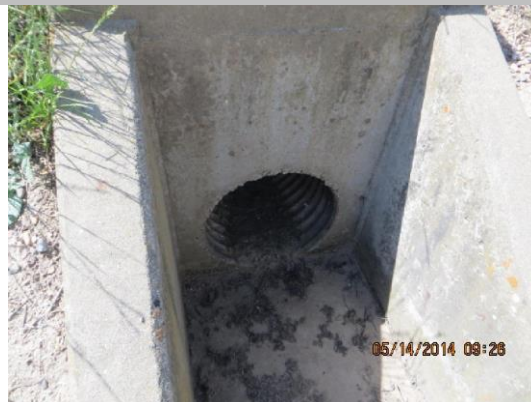
Photo 3 of 3 : UCIP_FA_2017_37753_68592.jpg

Pipe and headwall on LS toe.

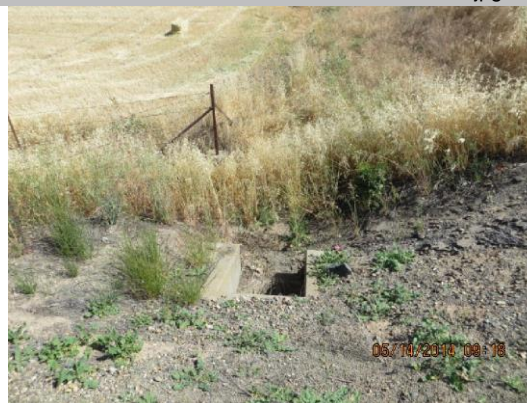
Photo 1 of 3 : UCIP_FA_2017_37752_68589.jpg

LM Start	11.88	Rating **	A/W	Issue No.	1125	
LM End	11.88	Issue Type +	Ma	Location *		
Category	Supplemental			GPS Latitude/Longitude		
				Start		End
Item	DWR UCIP LMA Responsibility			38.092270 °		38.092270 °
				-121.181332 °		-121.181332 °
DWR ID						
Comment Code						
Inspector Comment						
FS_ID:37752						
DS_ID:23594						
EP_NO: N/A						
Repair Type: No Action Needed						
Crossing Status: Found						
UCIP Comments:						
FIELD_STRUCT_DESC: 24-inch corrugated metal drainage pipe through the levee, 7.5 feet below the crown. Flap gate on the waterside (WS) end. Concrete U-shaped headwalls on both ends. Cobble grouted spillway across berm. Cobble grouted apron on the landside (LS) end. [Additional Reference(s): DWR Levee Log, 1987. USACE San Joaquin O&M Manual 612.2, 1967, (HLM 12.40)].						
FS Date: 5/14/2014

Pipe and headwall on LS toe.

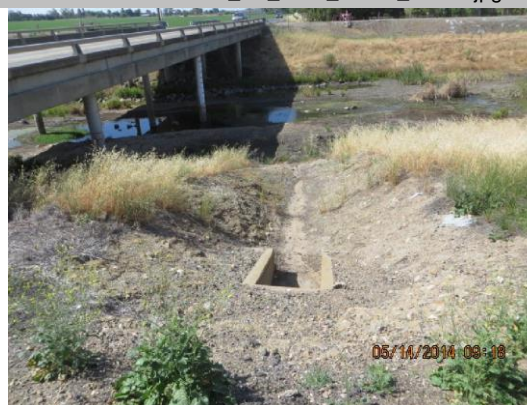
Photo 2 of 3 : UCIP_FA_2017_37752_68588.jpg

Pipe, flapgate, and headwall on WS toe.

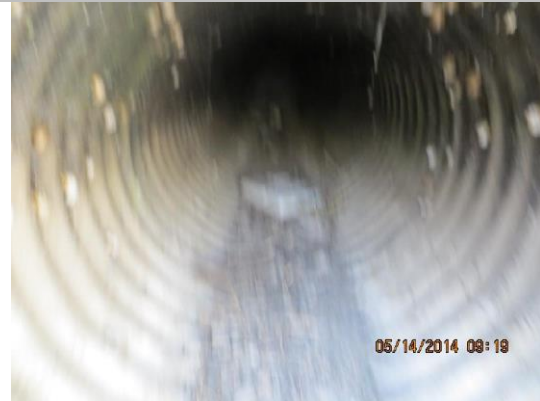
Photo 3 of 3 : UCIP_FA_2017_37752_68591.jpg

Inside pipe on LS toe.

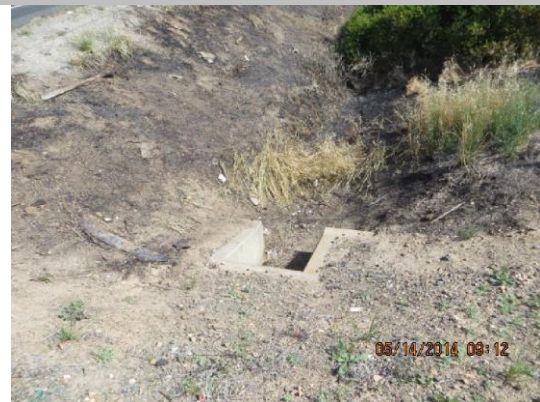
Photo 1 of 3 : UCIP_FA_2017_37751_68585.jpg

LM Start	11.90	Rating **	A/W	Issue No.	1126
LM End	11.90	Issue Type +	Ma	Location *	
Category	Supplemental			GPS Latitude/Longitude	
				Start	End
Item	DWR UCIP LMA Responsibility			38.092293 °	38.092293 °
				-121.181078 °	-121.181078 °
DWR ID					
Comment Code					
Inspector Comment					
FS_ID:37751 DS_ID:23505 EP_NO: N/A Repair Type: No Action Needed Crossing Status: Found UCIP Comments: FIELD_STRUCT_DESC: 24-inch corrugated metal drainage pipe through the levee, 7.5 feet below the crown. Flap gate on the waterside (WS) end. Concrete U-shaped headwalls on both ends. Cobble grouted spillway across the berm. Cobble grouted apron on the landside (LS) end. [Additional Reference(s): DWR Levee Log, 1987. USACE San Joaquin O&M Manual 612.2, 1967, (HLM 12.42)]. FS Date: 5/14/2014

Headwall and pipe on LS toe.

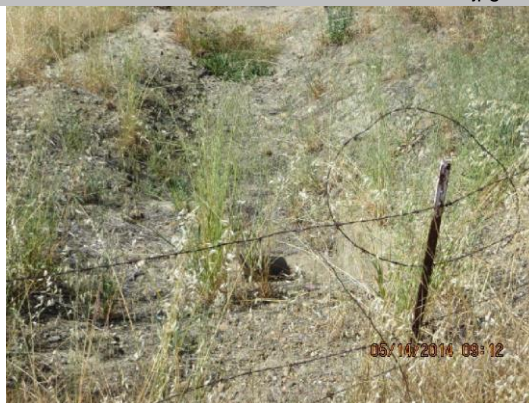
Photo 2 of 3 : UCIP_FA_2017_37751_68584.jpg

Headwall, pipe, and flapgate on WS toe.

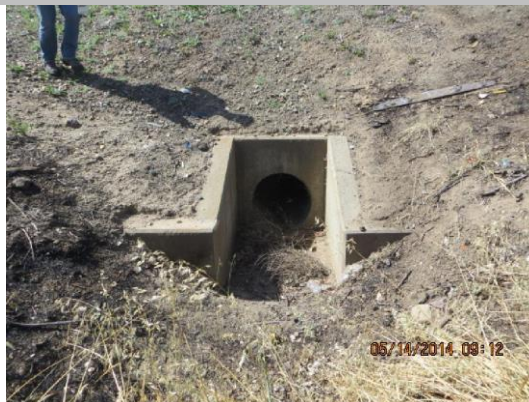
Photo 3 of 3 : UCIP_FA_2017_37751_68583.jpg

Headwall and pipe on LS toe.

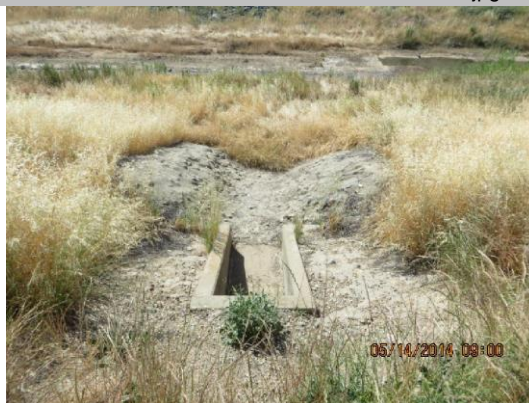
Photo 1 of 3 : UCIP_FA_2017_37745_68567.jpg

LM Start	12.12	Rating **	A/W	Issue No.	1127
LM End	12.12	Issue Type +	Ma	Location *	
Category	Supplemental			GPS Latitude/Longitude	
				Start	End
Item	DWR UCIP LMA Responsibility			38.093170 °	38.093170 °
				-121.177313 °	-121.177313 °
DWR ID					
Comment Code					
Inspector Comment					
FS_ID:37745 DS_ID:23507 EP_NO: N/A Repair Type: No Action Needed Crossing Status: Found UCIP Comments: FIELD_STRUCT_DESC: 24-inch corrugated metal storm drainage pipe through the levee, 7.5 feet below the crown. Flap gate on the waterside (WS) end. Concrete U-shaped headwalls on both ends. Cobble grouted spillway across the berm. Cobble grouted apron on the landside (LS) end. [Additional Reference(s): DWR Levee Log, 1987. USACE San Joaquin O&M Manual 612.2, 1967, (HLM 12.64) and 612 (addendum), February 1999, (HLM 12.61) (Station 666+02)]. FS Date: 5/14/2014

Pipe, flapgate, headwall, and grouted spillway on WS toe.

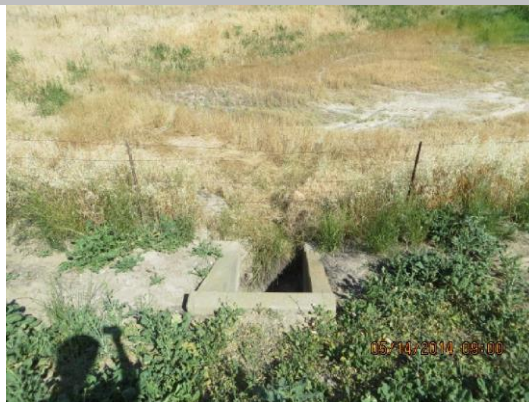
Photo 2 of 3 : UCIP_FA_2017_37745_68566.jpg

Pipe and headwall on LS toe.

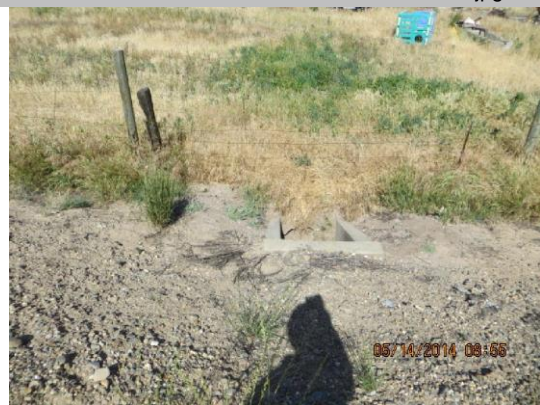
Photo 1 of 3 : UCIP_FA_2017_37732_68555.jpg

LM Start	12.19	Rating **	A/W	Issue No.	1128
LM End	12.19	Issue Type +	Ma	Location *	
Category	Supplemental			GPS Latitude/Longitude	
				Start	End
Item	DWR UCIP LMA Responsibility			38.094163 °	38.094163 °
				-121.176824 °	-121.176824 °
DWR ID					
Comment Code					
Inspector Comment					
FS_ID:37732 DS_ID:23508 EP_NO: N/A Repair Type: No Action Needed Crossing Status: Found UCIP Comments: FIELD_STRUCT_DESC: 24-inch corrugated metal storm drainage pipe through the levee, 7.5 feet below the crown. Flap gate on the waterside (WS) end. Concrete U-shaped headwalls on both ends. Cobble grouted spillway across the berm. Cobble grouted apron on the landside (LS) end. [Additional Reference(s): DWR Levee Log, 1987. USACE San Joaquin O&M Manual 612.2, 1967, (HLM 12.72) and 612 (addendum), February 1999, (HLM 12.71) (Station 671+24)]. FS Date: 5/14/2014

Pipe and headwall at LS toe.

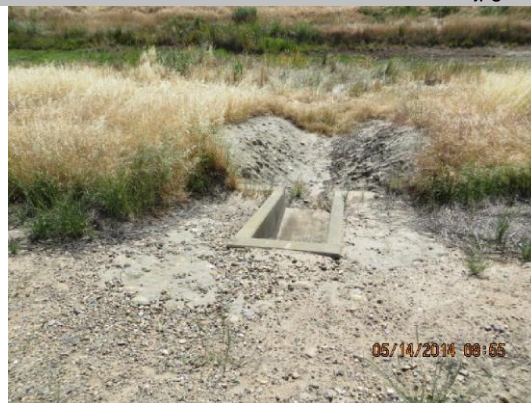
Photo 2 of 3 : UCIP_FA_2017_37732_68554.jpg

Pipe, flapgate, headwall, and grouted spillway on WS toe.

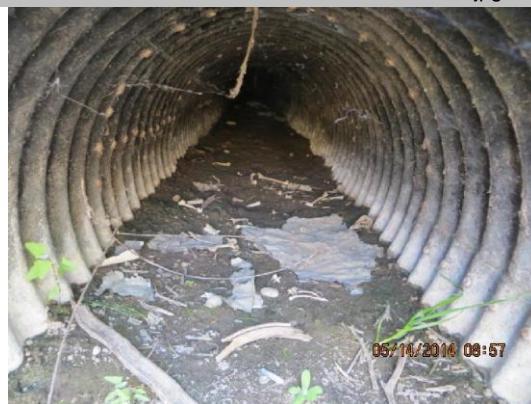
Photo 3 of 3 : UCIP_FA_2017_37732_68553.jpg

Inside pipe at LS toe.

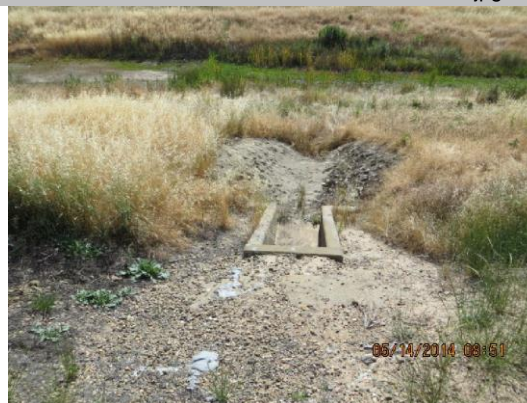
Photo 1 of 3 : UCIP_FA_2017_37731_68550.jpg

LM Start	12.21	Rating **	A/W	Issue No.	1129
LM End	12.21	Issue Type +	Ma	Location *	
Category	Supplemental			GPS Latitude/Longitude	
				Start	End
Item	DWR UCIP LMA Responsibility			38.094456 °	38.094456 °
				-121.176806 °	-121.176806 °
DWR ID					
Comment Code					
Inspector Comment					
FS_ID:37731 DS_ID:23509 EP_NO: N/A Repair Type: No Action Needed Crossing Status: Found UCIP Comments: FIELD_STRUCT_DESC: 24-inch corrugated metal storm drainage pipe through the levee, 7.5 feet below the crown. Flap gate on the waterside (WS) end. Concrete U-shaped headwalls on both ends. Cobble grouted spillway across the berm. Cobble grouted apron on the landside (LS) end. [Additional Reference(s): DWR Levee Log, 1987. USACE San Joaquin O&M Manual 612.2, 1967, (HLM 12.74) and 612 (addendum), February 1999, (HLM 12.73) (Station 672+05)]. FS Date: 5/14/2014

Pipe, flapgate, and headwall on WS toe.

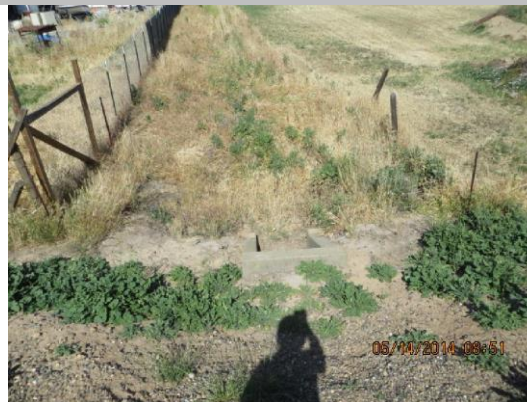
Photo 2 of 3 : UCIP_FA_2017_37731_68549.jpg

Pipe and headwall on LS toe.

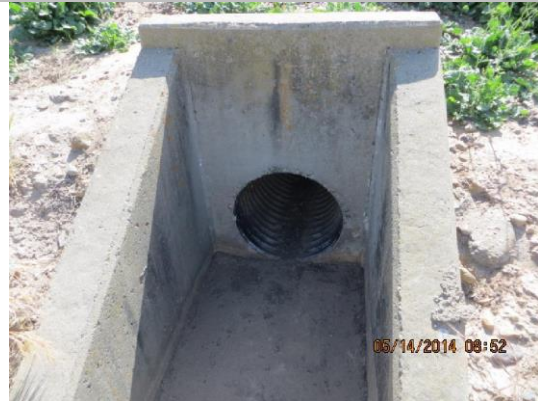
Photo 3 of 3 : UCIP_FA_2017_37731_68548.jpg

Pipe and headwall on LS toe.

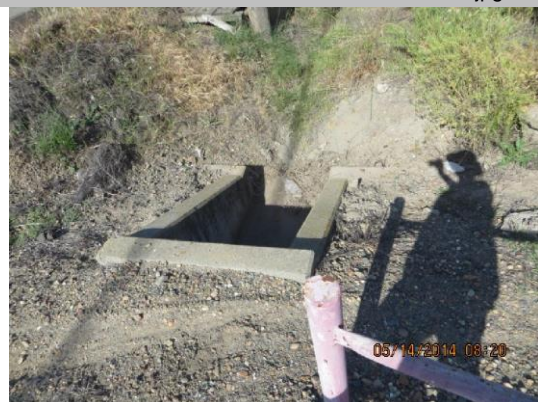
Photo 1 of 3 : UCIP_FA_2017_37719_68528.jpg

LM Start	12.74	Rating **	A/W	Issue No.	1131
LM End	12.74	Issue Type +	Ma	Location *	
Category	Supplemental			GPS Latitude/Longitude	
				Start	End
Item	DWR UCIP LMA Responsibility			38.101797 °	38.101797 °
				-121.177750 °	-121.177750 °
DWR ID					
Comment Code					
Inspector Comment					
FS_ID:37719					
DS_ID:23512					
EP_NO: N/A					
Repair Type: No Action Needed					
Crossing Status: Found					
UCIP Comments:					
FIELD_STRUCT_DESC: 24-inch corrugated metal drainage pipe through the levee, 7 feet below the crown. Concrete U-shaped headwall on both ends. Flap gate on the waterside (WS) end. Cobble grouted spillway. Cobble grouted intake on the landside (LS). [Additional Reference(s): DWR Levee Log, 1987. USACE San Joaquin O&M Manual 612.2, 1967, (HLM 13.29)].					
FS Date: 5/14/2014

Pipe and headwall on LS toe.

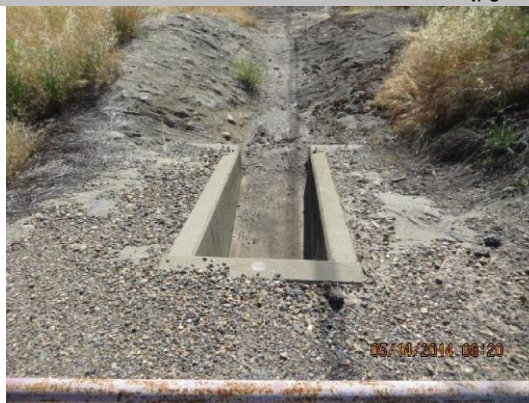
Photo 2 of 3 : UCIP_FA_2017_37719_68527.jpg

Pipe, flapgate, and headwall on WS toe.

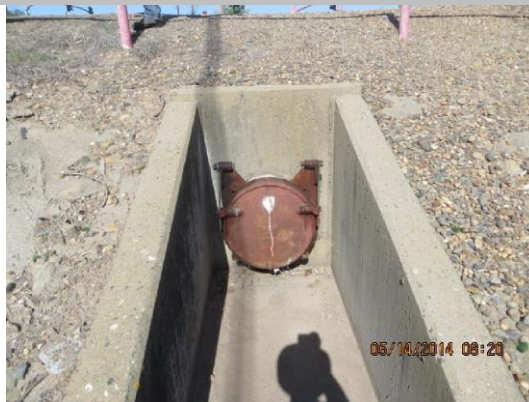
Photo 3 of 3 : UCIP_FA_2017_37719_68526.jpg

Pipe, flapgate, and headwall on WS toe.

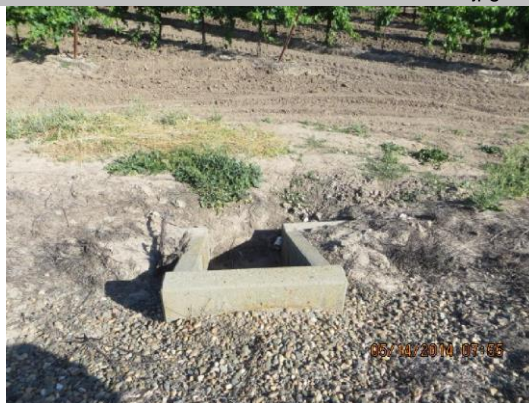
Photo 1 of 3 : UCIP_FA_2017_37690_68450.jpg

LM Start	13.09	Rating **	A/W	Issue No.	1137	
LM End	13.09	Issue Type +	Ma	Location *		
Category	Supplemental			GPS Latitude/Longitude		
				Start		End
Item	DWR UCIP LMA Responsibility			38.106393 °		38.106393 °
				-121.175587 °		-121.175587 °
DWR ID						
Comment Code						
Inspector Comment						
FS_ID:37690						
DS_ID:23597						
EP_NO: N/A						
Repair Type: No Action Needed						
Crossing Status: Found						
UCIP Comments:						
FIELD_STRUCT_DESC: 24-inch corrugated metal drainage pipe through the levee, 5.5 feet below the crown. Concrete U-shaped headwall on both ends. Flap gate on the waterside (WS) slope. Cobble grouted spillway. Cobble grouted intake on the landside (LS). [Additional Reference(s): DWR Levee Log, 1987. USACE San Joaquin O&M Manual 612.2, 1967, (HLM 13.64)].						
FS Date: 5/14/2014

Pipe and headwall on LS toe.

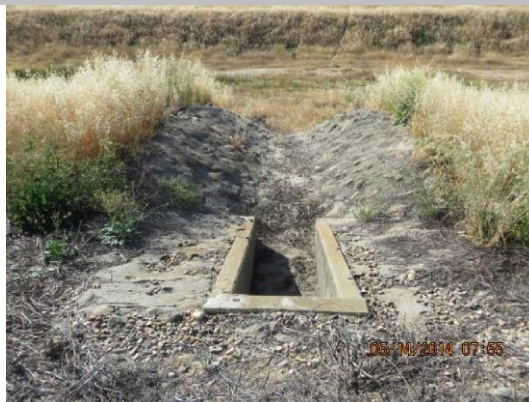
Photo 2 of 3 : UCIP_FA_2017_37690_68449.jpg

Pipe, flapgate, headwall, and grouted spillway on WS slope.

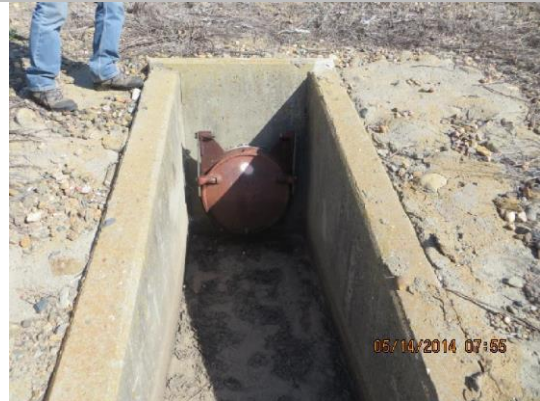
Photo 3 of 3 : UCIP_FA_2017_37690_68448.jpg

Pipe, flapgate, headwall, and grouted spillway on WS slope.

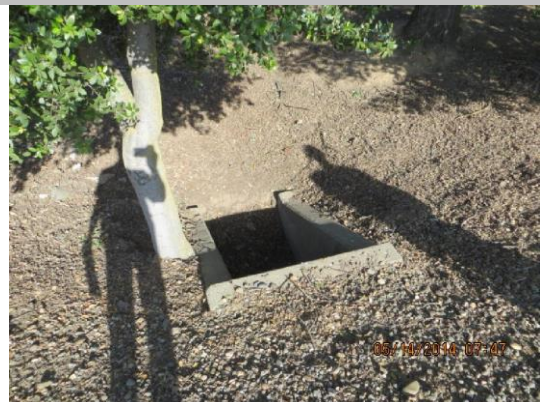
Photo 1 of 3 : UCIP_FA_2017_37689_68446.jpg

LM Start	13.48	Rating **	A/W	Issue No.	1138
LM End	13.48	Issue Type +	Ma	Location *	
Category	Supplemental			GPS Latitude/Longitude	
				Start	End
Item	DWR UCIP LMA Responsibility			38.111310 °	38.111310 °
				-121.172760 °	-121.172760 °
DWR ID					
Comment Code					
Inspector Comment					
FS_ID:37689 DS_ID:23598 EP_NO: N/A Repair Type: No Action Needed Crossing Status: Found UCIP Comments: FIELD_STRUCT_DESC: 24-inch corrugated metal drainage pipe through the levee, 7.5 feet below the crown. Concrete U-shaped headwall on both ends. Flap gate on the waterside (WS) end. Cobble grouted spillway. Cobble grouted intake on the landside (LS) slope. [Additional Reference(s): DWR Levee Log, 1987. USACE San Joaquin O&M Manual 612.2, 1967, (HLM 14.04)]. FS Date: 5/14/2014

Pipe and concrete headwall on LS slope.

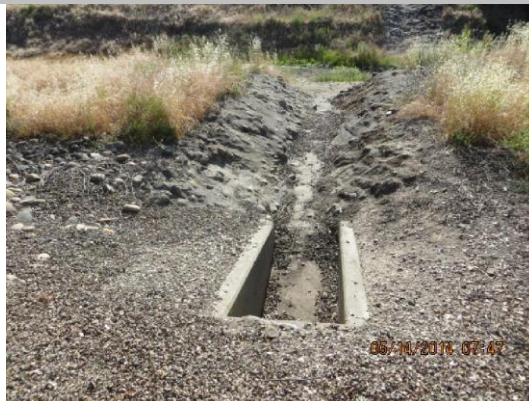
Photo 2 of 3 : UCIP_FA_2017_37689_68445.jpg

Pipe, flapgate, headwall, and grouted spillway on WS slope.

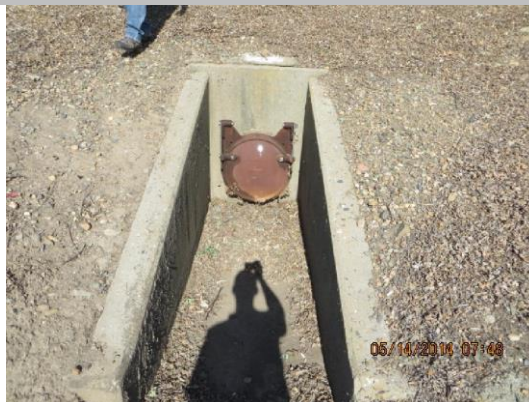
Photo 3 of 3 : UCIP_FA_2017_37689_68444.jpg

Pipe, flapgate, headwall, and grouted spillway on WS slope.

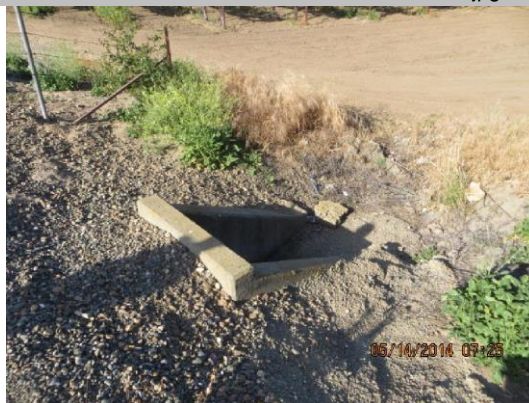
Photo 1 of 3 : UCIP_FA_2017_37675_68408.jpg

Pipe and concrete headwall on LS toe.

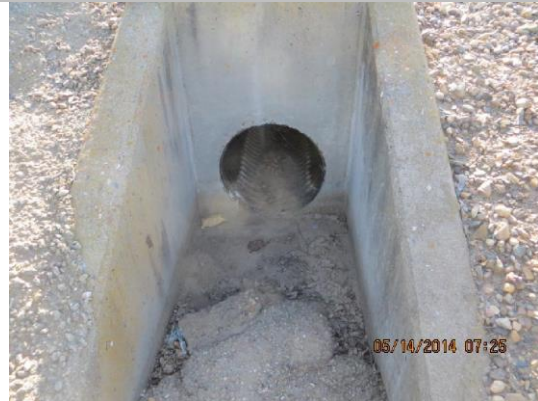
Photo 3 of 3 : UCIP_FA_2017_37675_68402.jpg

Pipe and concrete headwall on LS toe.

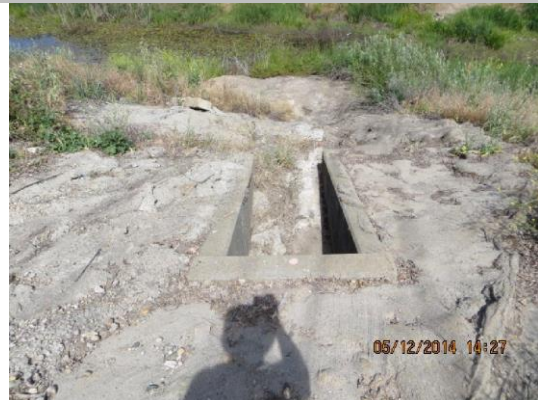
Photo 1 of 3 : UCIP_FA_2017_37666_68385.jpg

Pipe, flapgate, and headwall on WS slope.

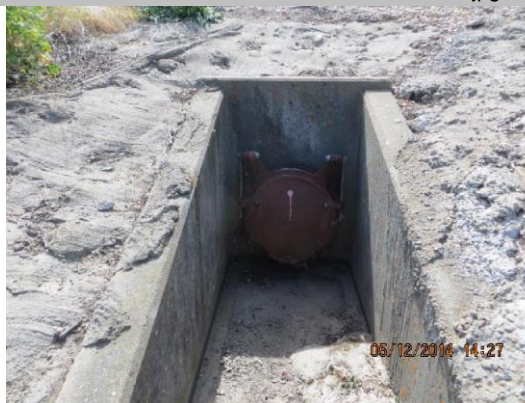
Photo 2 of 3 : UCIP_FA_2017_37666_68384.jpg

Pipe, flapgate, and headwall on WS slope.

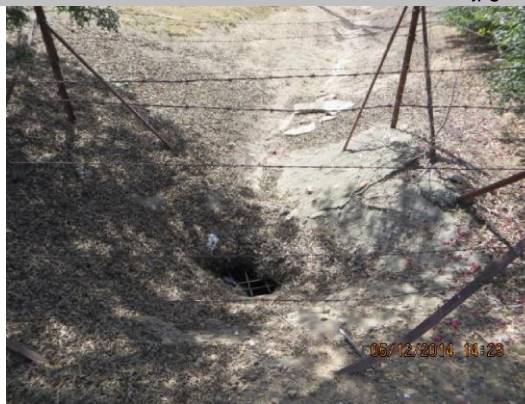
Photo 3 of 3 : UCIP_FA_2017_37666_68383.jpg

Drop-inlet on LS toe.

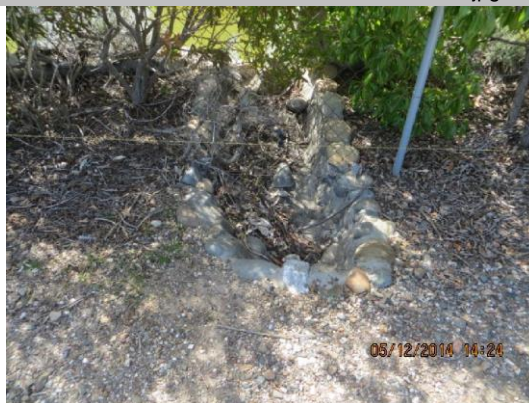
Photo 1 of 3 : UCIP_FA_2017_37663_68359.jpg

Cobble grouted inlet from fish pond on LS toe.

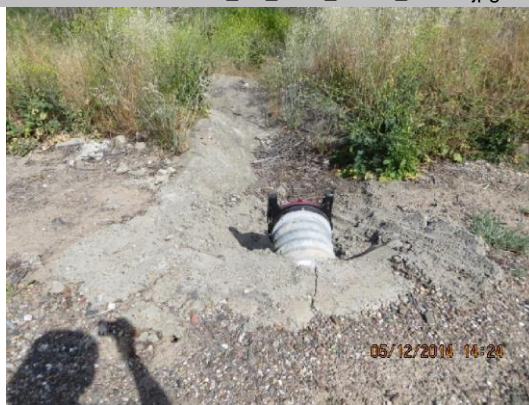
Photo 2 of 3 : UCIP_FA_2017_37663_68358.jpg

Pipe, flapgate, and grouted spillway on WS slope.

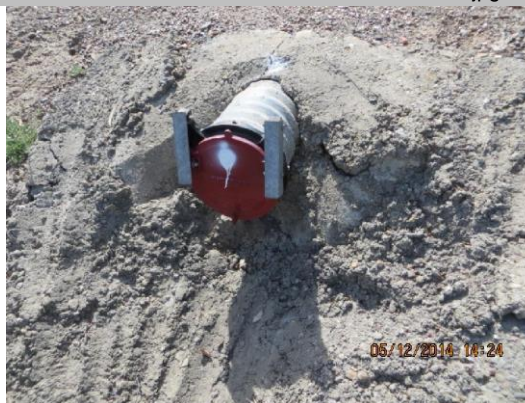
Photo 3 of 3 : UCIP_FA_2017_37663_68357.jpg

Pipe, flapgate, and grouted spillway on WS slope.

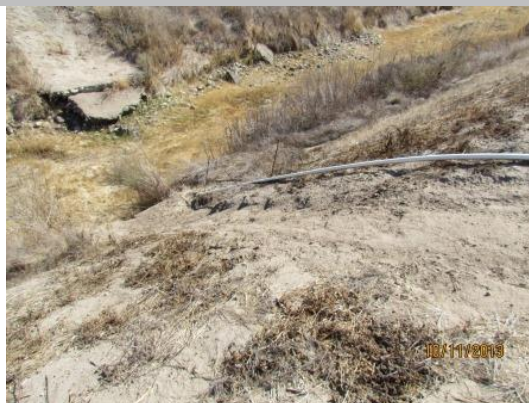
Photo 1 of 1 : FA_2017_NA0017_151_61_20170921_00022.jpg

LM Start	14.23	Rating **	M	Issue No.	61
LM End	14.23	Issue Type +	Ma	Location *	WS
Category	Earthen Levee			GPS Latitude/Longitude	
				Start	End
Item	Encroachments			38.121625 °	38.121625 °
				-121.169563 °	-121.169563 °
DWR ID	DWR_NA0017_07_f_2013_61				
Comment Code					
ST : Stairway					
Inspector Comment

Steps were found on the waterside slope of the levee looking downstream.

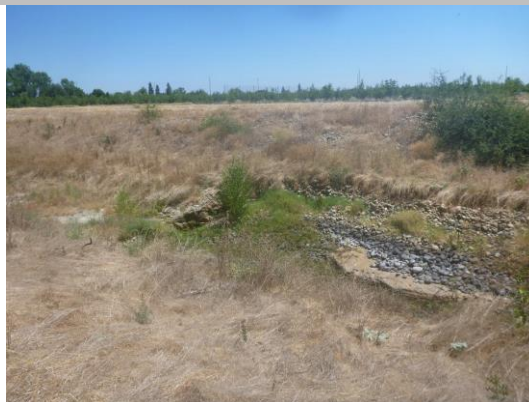
Photo 1 of 3 : LEVAL_FA_2017_478_2262.jpg

LM Start	14.27	Rating **	A/W	Issue No.	139
LM End	14.27	Issue Type +	Ma	Location *	
Category	Supplemental			GPS Latitude/Longitude	
				Start	End
Item	2017 Storm Damage			38.122152 °	38.122152 °
				-121.169461 °	-121.169461 °
DWR ID	DWR_NA0017_07_f_2017_139

Comment Code					
Inspector Comment					
Levee Evaluation Comments					
Description:Erosion on the waterside toe of the levee. The Lat, Long above is from the Spring DWR inspection report, which took the photo and GPS from the right bank. The erosion is on the left bank.					
Site ID No:478					
Site Designation:LMA-305					
Repair Type: Erosion					
Rating:Area of Concern					
Field Date:7/27/2017					
Notes: Levee is small, but there is a fairly large berm. Erosion is present on both banks with 8 ft scarp. There is a big drop in the channel bottom here that could cause eddies and faster erosion.					
Riprap is just cobble, not clean rock.

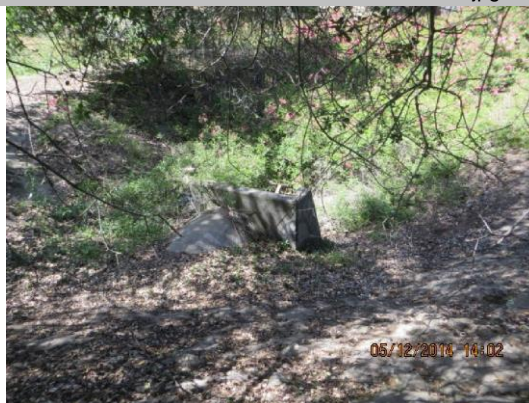
Photo 1 of 3 : UCIP_FA_2017_37660_68354.jpg

Pipe and headwall on LS toe.

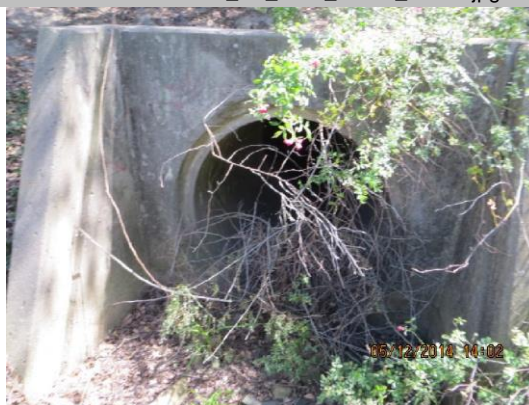
Photo 2 of 3 : UCIP_FA_2017_37660_68353.jpg

Pipe and headwall on LS toe.

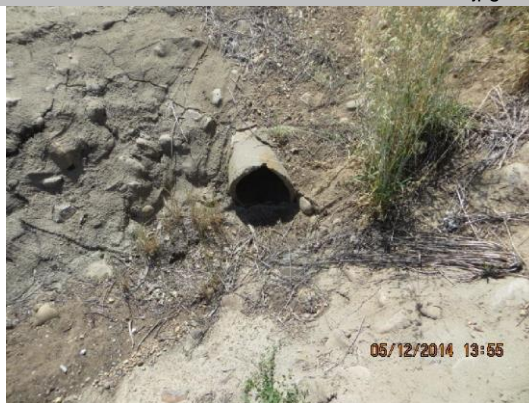
Photo 2 of 3 : UCIP_FA_2017_37658_68342.jpg

Grouted spillway and pipe visible on WS slope.

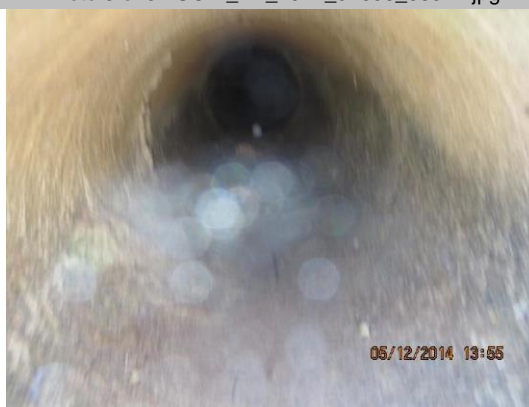
Photo 3 of 3 : UCIP_FA_2017_37658_68341.jpg

Inside pipe at WS slope.

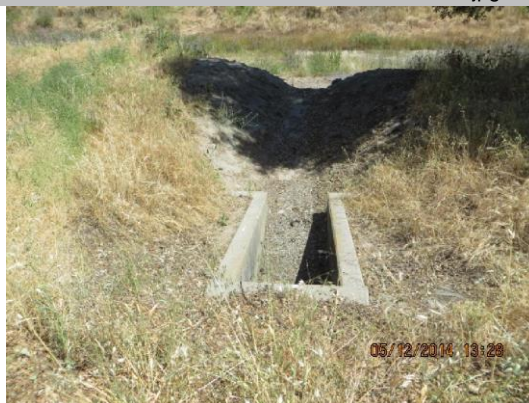
Photo 1 of 3 : UCIP_FA_2017_37655_68336.jpg

Pipe, flapgate, concrete headwall, and grouted spillway on WS slope.

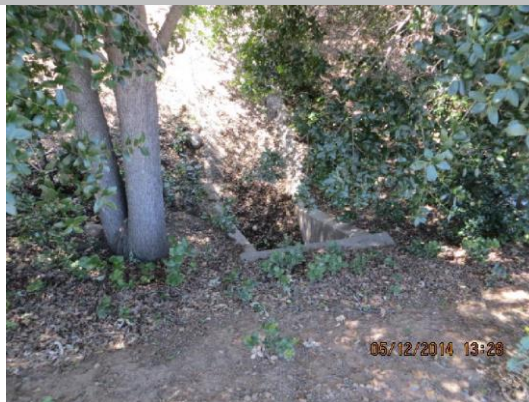
Photo 2 of 3 : UCIP_FA_2017_37655_68335.jpg

Concrete headwall and pipe at LS toe.

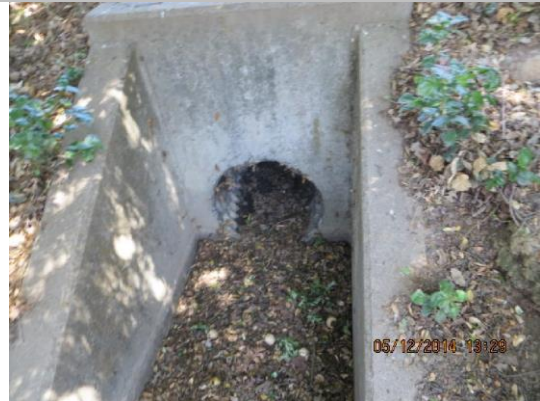
Photo 3 of 3 : UCIP_FA_2017_37655_68334.jpg

Concrete headwall and pipe at LS toe.

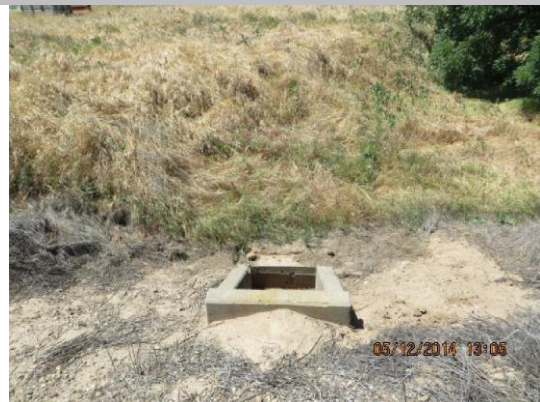
Photo 1 of 3 : UCIP_FA_2017_37653_68329.jpg

Concrete headwall on LS toe.

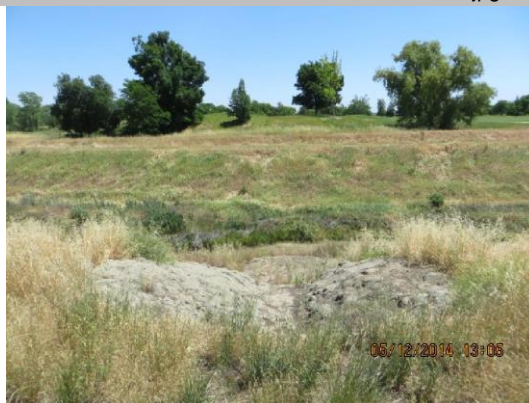
Photo 2 of 3 : UCIP_FA_2017_37653_68328.jpg

Grouted spillway on WS slope.

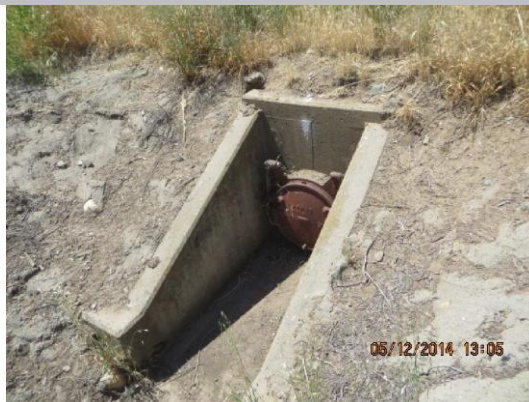
Photo 3 of 3 : UCIP_FA_2017_37653_68327.jpg

Pipe, flapgate, headwall, and grouted spillway on WS slope.

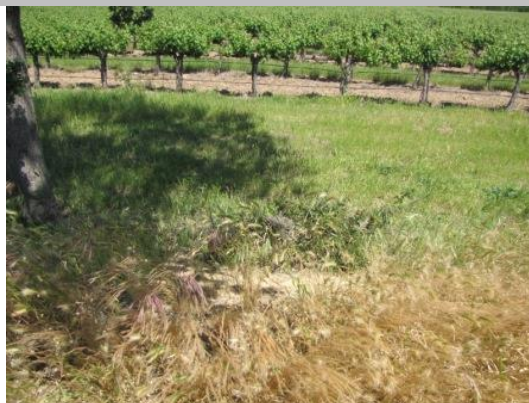
Photo 1 of 1 : FA_2017_NA0017_151_53_20170921_00020.jpg

LM Start	15.16	Rating **	N	Issue No.	53
LM End	15.16	Issue Type +	Ma	Location *	LS
Category	Earthen Levee			GPS Latitude/Longitude	
				Start	End
Item	Trim / Thin Trees			38.130231 °	38.130231 °
				-121.158447 °	-121.158447 °
DWR ID	DWR_NA0017_07_s_2012_53				
Comment Code					
T5 : Tree stumps.					
Inspector Comment

View of a stump in the landward slope.

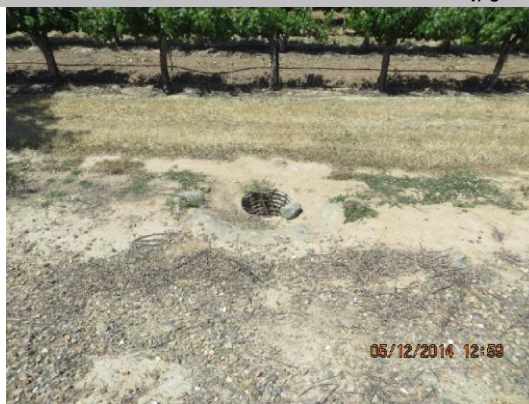
Photo 1 of 3 : UCIP_FA_2017_37652_68326.jpg

LM Start	15.22	Rating **	M	Issue No.	1154	
LM End	15.22	Issue Type +	Ma	Location *		
Category	Supplemental			GPS Latitude/Longitude		
				Start	End	
Item	DWR UCIP LMA Responsibility			38.130318 °	38.130318 °	
				-121.157417 °	-121.157417 °	
DWR ID						
Comment Code						
Inspector Comment						
FS_ID:37652 DS_ID:23610 EP_NO: N/A Repair Type: Non-Urgent Crossing Status: Found UCIP Comments: No inlet cover or grate at LS toe FIELD_STRUCT_DESC: 24-inch corrugated metal drainage pipe through the levee, 11 feet below the crown. Concrete U-shaped headwall on the waterside (WS) end. Flap gate on the WS end. 24-inch corrugated metal riser unit/drop inlet on the landside (LS). [Additional Reference(s): DWR Levee Log, 1987. USACE San Joaquin O&M Manual 612.2, 1967, (HLM 15.80)]. FS Date: 5/12/2014

24-inch riser/dropinlet on LS toe.
