**Flood Control Project Maintenance
Levee Inspections**

Maintenance Issue Types Only, Levee Inspection Report By Mile - Fall 2017

San Joaquin County Flood Control and Water Conservation District

Waterway	Bank	Unit Miles	Inspection Start/End	Inspector
Unit No. 01 Littlejohn Creek	Left	2.59	10/17/2017 10/17/2017	Pavel Kazi

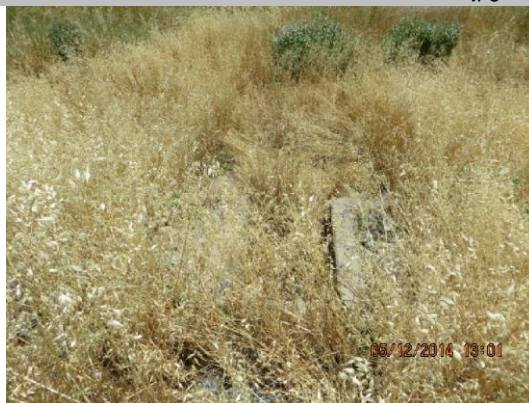
Photo 2 of 3 : UCIP_FA_2017_37652_68325.jpg

Concrete headwall on WS toe.

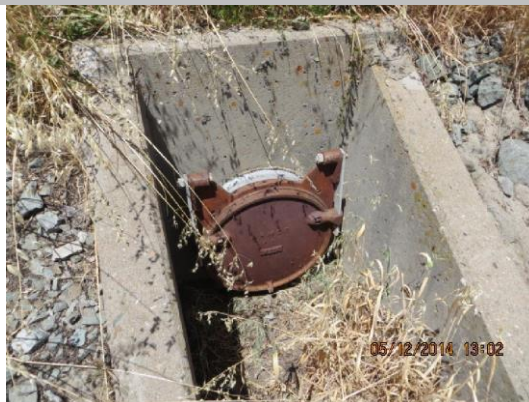
Photo 3 of 3 : UCIP_FA_2017_37652_68324.jpg

Pipe, flapgate, and Concrete headwall on WS slope.

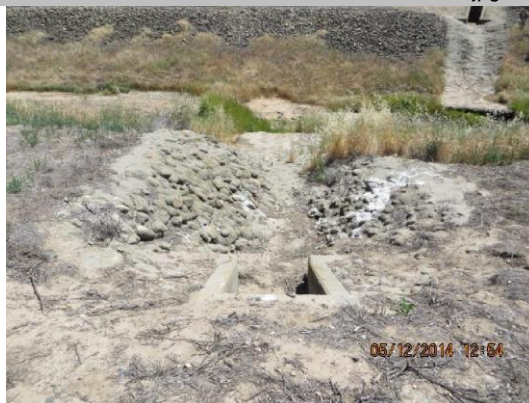
Photo 1 of 3 : UCIP_FA_2017_37651_68322.jpg

Concrete headwall and grouted spillway on WS slope.

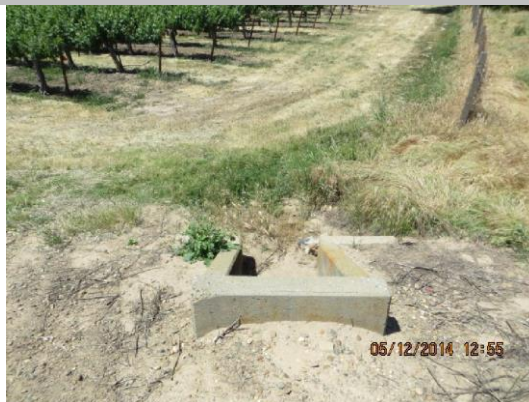
Photo 2 of 3 : UCIP_FA_2017_37651_68321.jpg

concrete headwall on LS toe.

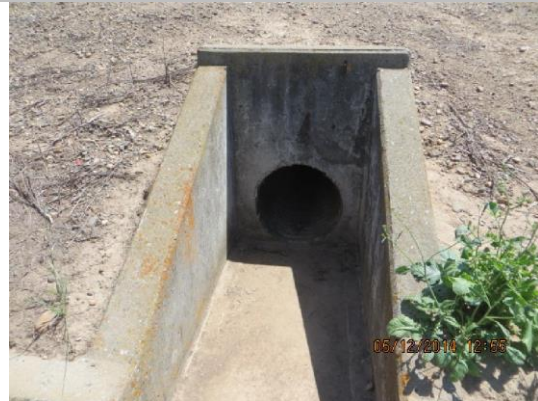
Photo 3 of 3 : UCIP_FA_2017_37651_68320.jpg

concrete headwall on LS toe.

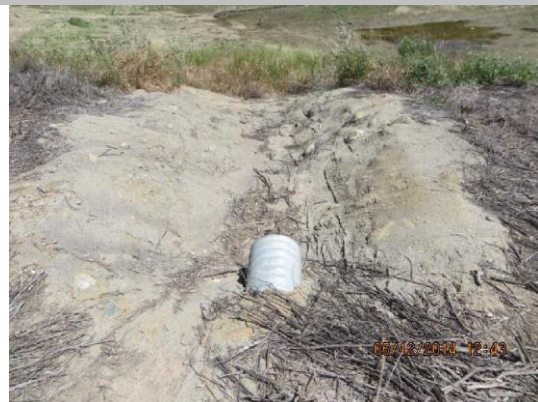
Photo 1 of 3 : UCIP_FA_2017_51623_68319.jpg

LM Start	15.51	Rating **	U	Issue No.	1156
LM End	15.51	Issue Type +	Ma	Location *	
Category	Supplemental			GPS Latitude/Longitude	
				Start	End
Item	DWR UCIP LMA Responsibility			38.132632 °	38.132632 °
				-121.153838 °	-121.153838 °
DWR ID					
Comment Code					
Inspector Comment					
FS_ID:51623 DS_ID:23612 EP_NO: N/A Repair Type: Urgent Crossing Status: Found UCIP Comments: 04/20/2017 Pipe is open on both ends. Requires a positive closure device. Crossing has been upgraded from No Action Needed to Urgent. (K. Fazel - UCIP) FIELD_STRUCT_DESC: 12-inch corrugated metal drainage pipe through the levee, 1.5 feet below the crown. Cobble grouted spillway. Open on both ends. [Additional Reference(s): DWR Levee Log, 1987. USACE San Joaquin O&M Manual 612.2, 1967, (HLM 16.10)]. FS Date: 5/12/2014

Pipe visible on WS slope with grouted spillway.

FS_ID:51623
DS_ID:23612
EP_NO: N/A
Repair Type: Urgent
Crossing Status: Found
UCIP Comments: 04/20/2017 Pipe is open on both ends. Requires a positive closure device. Crossing has been upgraded from No Action Needed to Urgent. (K. Fazel - UCIP)
FIELD_STRUCT_DESC: 12-inch corrugated metal drainage pipe through the levee, 1.5 feet below the crown. Cobble grouted spillway. Open on both ends. [Additional Reference(s): DWR Levee Log, 1987. USACE San Joaquin O&M Manual 612.2, 1967, (HLM 16.10)].
FS Date: 5/12/2014

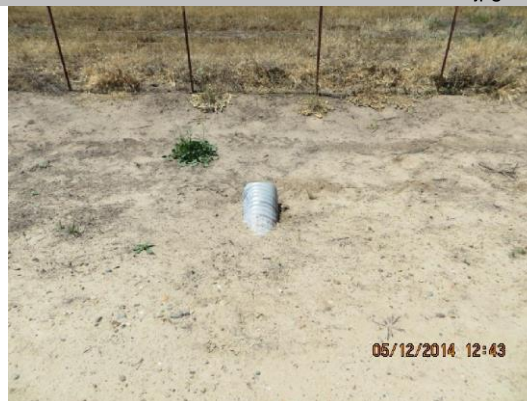
Photo 2 of 3 : UCIP_FA_2017_51623_68318.jpg

Pipe at inlet on LS toe.

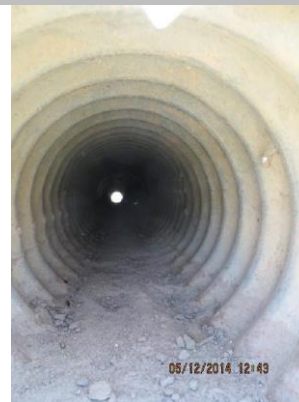
Photo 3 of 3 : UCIP_FA_2017_51623_68317.jpg

Inside pipe at LS toe.

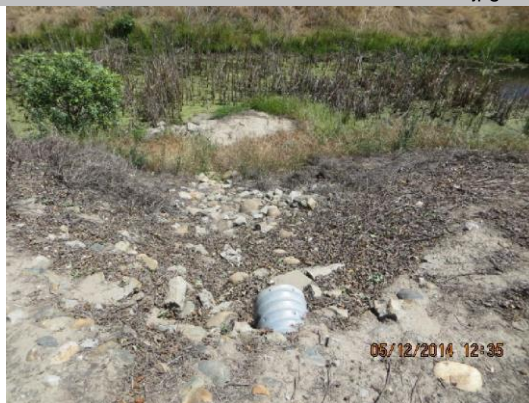
Photo 1 of 3 : UCIP_FA_2017_51624_68316.jpg

FS_ID:51624
DS_ID:23614
EP_NO: N/A
Repair Type: Urgent
Crossing Status: Found
UCIP Comments: 04/20/2017 Pipe is open on both ends. Requires a positive closure device. Crossing has been upgraded from No Action Needed to Urgent. (K. Fazel - UCIP)
FIELD_STRUCT_DESC: 12-inch corrugated metal drainage pipe through the levee, 2 feet below the crown. Cobble grouted spillway. Open on both ends. [Additional Reference(s): DWR Levee Log, 1987. USACE San Joaquin O&M Manual 612.2, 1967, (HLM 16.32)].
FS Date: 5/12/2014

Pipe on WS slope.

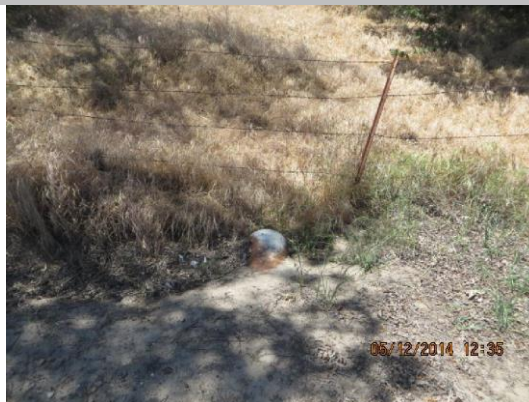
Photo 2 of 3 : UCIP_FA_2017_51624_68315.jpg

Pipe at inlet on LS shoulder.

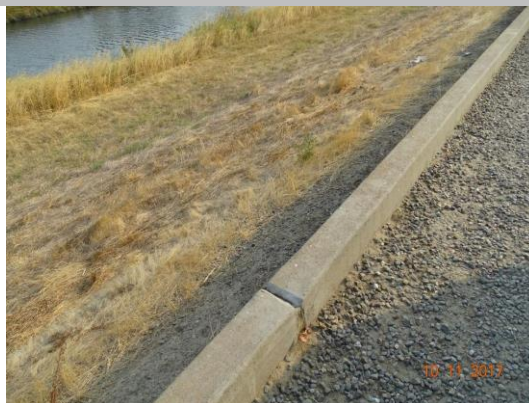
Photo 1 of 1 : FA_2017_NA0017_152_162_20171016_00507.jpg

LM Start	1.43	Rating **	M	Issue No.	162
LM End	1.43	Issue Type +	Ma	Location *	WS
Category	Concrete Floodwalls			GPS Latitude/Longitude	
				Start	End
Item	Monolith Joints			38.042861 °	38.042861 °
				-121.357973 °	-121.357973 °
DWR ID	DWR_NA0017_08_f_2017_162				
Comment Code					
Inspector Comment					
This portion of the floodwall has deteriorated monolith joints.

View of damaged monolith joint on the waterside shoulder of the levee.
Fall 2017

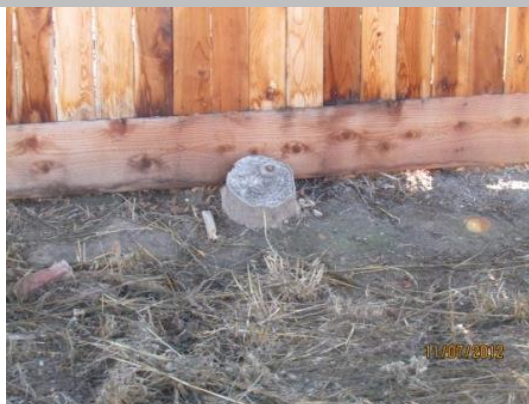
Photo 1 of 1 : FA_2017_NA0017_152_18_20170921_00005.jpg

LM Start	1.82	Rating **	N	Issue No.	18	
LM End	1.82	Issue Type +	Ma	Location *	LS	
Category	Earthen Levee			GPS Latitude/Longitude		
				Start		End
Item	Trim / Thin Trees			38.042751 °		38.042751 °
				-121.353062 °		-121.353062 °
DWR ID	DWR_NA0017_08_f_2012_18					
Comment Code						
T5 : Tree stumps.						
Inspector Comment

View of a tree stump that was found on the landside toe of the levee.
The picture was taken from the crown looking towards the toe.

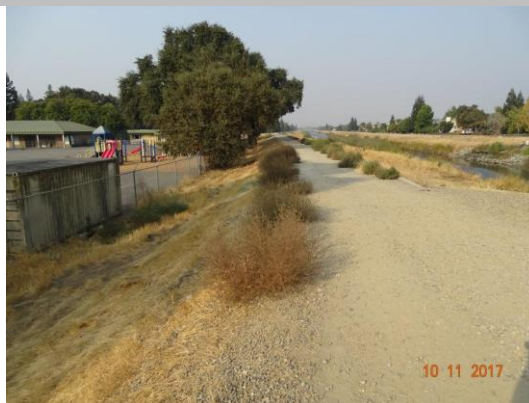
Photo 1 of 1 : FA_2017_NA0017_152_159_20171016_00504.jpg

LM Start	1.93	Rating **	M	Issue No.	159
LM End	1.96	Issue Type +	Ma	Location *	WS
Category	Earthen Levee			GPS Latitude/Longitude	
				Start	End
Item	Vegetation			38.042810 °	38.042815 °
				-121.348813 °	-121.348342 °
DWR ID	DWR_NA0017_08_f_2017_159				
Comment Code					
V2 : Remove the wild growth other than native grasses from the levee slopes.					
Inspector Comment

View of the vegetation on the waterside shoulder of the levee looking downstream. Fall 2017

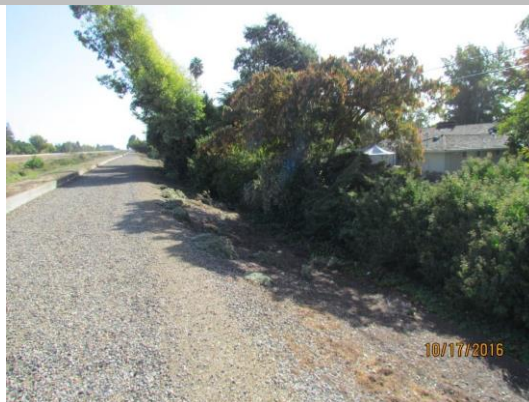
Photo 1 of 1 : FA_2017_NA0017_152_115_20170921_00029.jpg

LM Start	2.01	Rating **	M	Issue No.	115
LM End	2.11	Issue Type +	Ma	Location *	LS
Category	Earthen Levee			GPS Latitude/Longitude	
				Start	End
Item	Trim / Thin Trees			38.042801 °	38.042778 °
				-121.347390 °	-121.345589 °
DWR ID	DWR_NA0017_08_f_2016_115				
Comment Code					
T2 : Thin trees to allow visibility of the ground and room to flood fight.					
Inspector Comment

View of the tree limbs on the landside of the levee. Fall 2016.

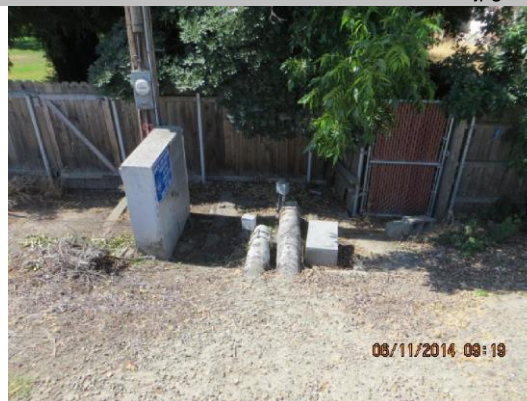
Photo 1 of 3 : UCIP_FA_2017_38523_70515.jpg

Pipe at pump and sump on LS toe next to Pole and electrical panel.

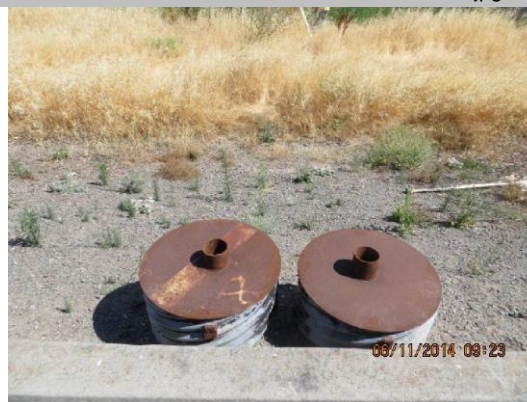
Photo 2 of 3 : UCIP_FA_2017_38523_70514.jpg

Siphon Breaker in CMP riser on WS shoulder.

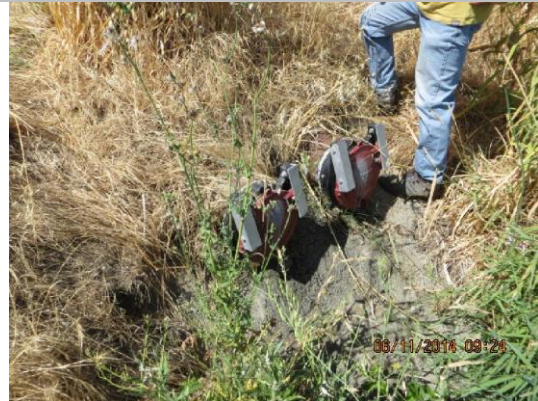
Photo 3 of 3 : UCIP_FA_2017_38523_70513.jpg

flapgate on WS slope.

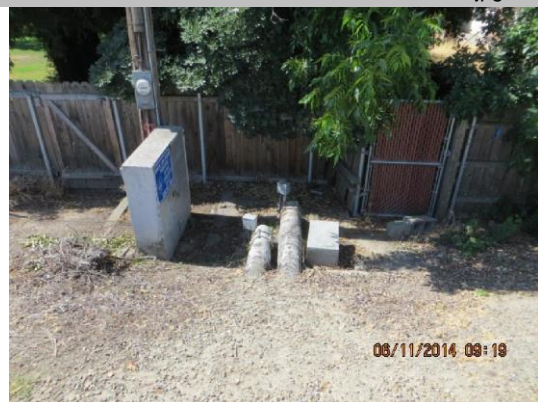
Photo 1 of 3 : UCIP_FA_2017_38524_70518.jpg

Pipe, pump, electrical panel, and pole visible on LS toe.

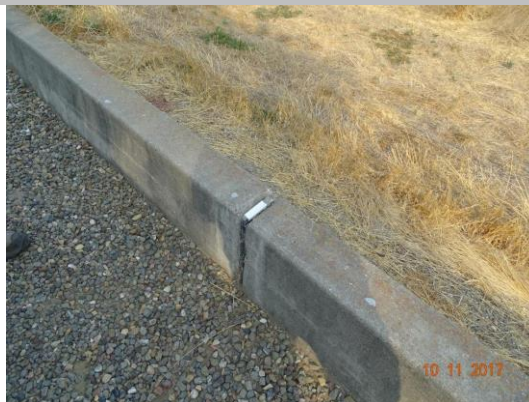
Photo 1 of 1 : FA_2017_NA0017_152_163_20171016_00508.jpg

LM Start	2.17	Rating **	M	Issue No.	163
LM End	2.17	Issue Type +	Ma	Location *	WS
Category	Concrete Floodwalls			GPS Latitude/Longitude	
				Start	End
Item	Monolith Joints			38.042765 °	38.042765 °
				-121.344432 °	-121.344432 °
DWR ID	DWR_NA0017_08_f_2017_163				
Comment Code					
Inspector Comment					
This portion of the floodwall has deteriorated monolith joints.

View of a damaged monolith joint on the waterside shoulder of the levee.
Fall 2017

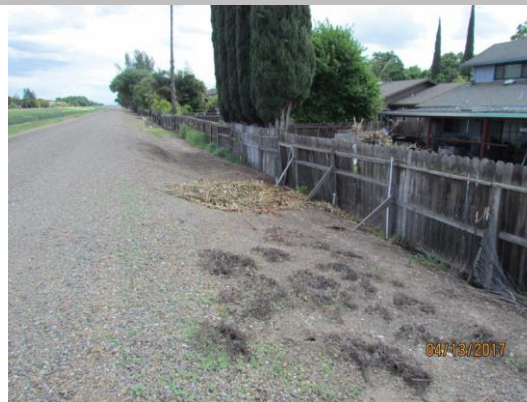
Photo 1 of 1 : FA_2017_NA0017_152_169_20170921_00043.jpg

LM Start	2.40	Rating **	M	Issue No.	169
LM End	2.40	Issue Type +	Ma	Location *	LS
Category	Earthen Levee			GPS Latitude/Longitude	
				Start	End
Item	Encroachments			38.042760 °	38.042760 °
				-121.340299 °	-121.340299 °
DWR ID	DWR_NA0017_08_s_2017_169				
Comment Code					
PR : Prunings					
Inspector Comment

View of prunings on the landside toe of the levee.

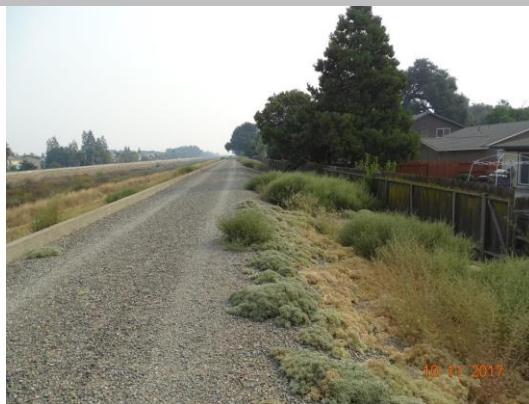
Photo 1 of 1 : FA_2017_NA0017_152_59_20171016_00510.jpg

LM Start	2.50	Rating **	M	Issue No.	59
LM End	2.54	Issue Type +	Ma	Location *	LS
Category	Earthen Levee			GPS Latitude/Longitude	
				Start	End
Item	Vegetation			38.042727 °	38.042736 °
				-121.338422 °	-121.337605 °
DWR ID	DWR_NA0017_08_f_2015_59				
Comment Code					
V2 : Remove the wild growth other than native grasses from the levee slopes.					
Inspector Comment

View of vegetation on the landside slope of the levee looking upstream.
Fall 2017

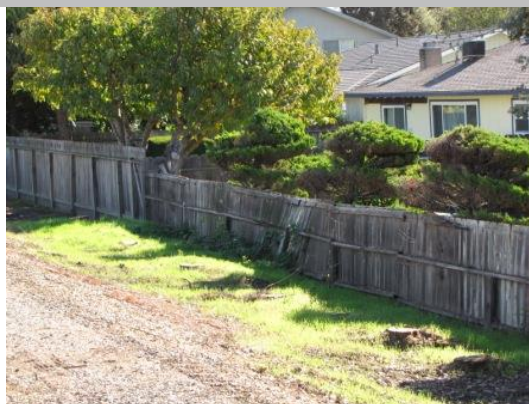
Photo 1 of 1 : FA_2017_NA0017_152_12_20170921_00003.jpg

LM Start	2.50	Rating **	N	Issue No.	12
LM End	2.50	Issue Type +	Ma	Location *	LS
Category	Earthen Levee			GPS Latitude/Longitude	
				Start	End
Item	Trim / Thin Trees			38.042749 °	38.042749 °
				-121.338402 °	-121.338402 °
DWR ID	DWR_NA0017_08_s_2012_12				
Comment Code					
T5 : Tree stumps.					
Inspector Comment

View of stumps along the landward toe looking upstream.

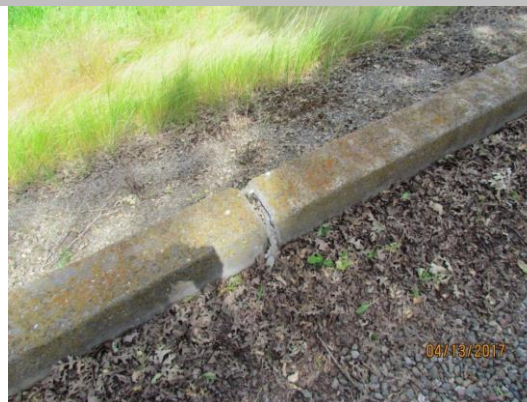
Photo 1 of 1 : FA_2017_NA0017_152_171_20170921_00045.jpg

LM Start	2.79	Rating **	M	Issue No.	171
LM End	2.79	Issue Type +	Ma	Location *	WS
Category	Concrete Floodwalls			GPS Latitude/Longitude	
				Start	End
Item	Monolith Joints			38.042710 °	38.042710 °
				-121.333020 °	-121.333020 °
DWR ID	DWR_NA0017_08_s_2017_171				
Comment Code					
Inspector Comment					
This portion of the floodwall has deteriorated monolith joints.

View of a deteriorated monolith joint on the waterside shoulder of the levee. Spring 2017

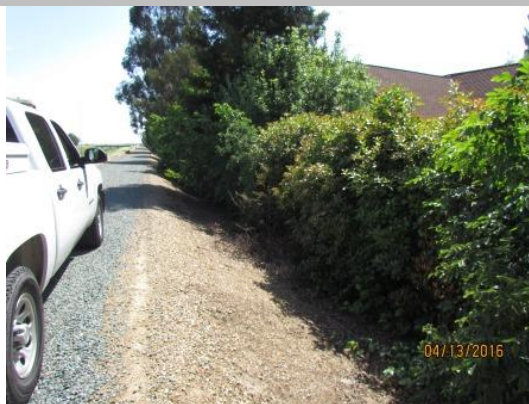
Photo 1 of 1 : FA_2017_NA0017_152_138_20170921_00041.jpg

LM Start	3.11	Rating **	M	Issue No.	138
LM End	3.14	Issue Type +	Ma	Location *	LS
Category	Earthen Levee			GPS Latitude/Longitude	
				Start	End
Item	Trim / Thin Trees			38.042654 °	38.042646 °
				-121.327229 °	-121.326561 °
DWR ID	DWR_NA0017_08_s_2016_138				
Comment Code					
T3 : Trim and thin trees to allow visibility of the ground and room to flood fight.					
Inspector Comment

View of tree limbs that were blocking the visibility and accessibility of the landside slope of the levee.

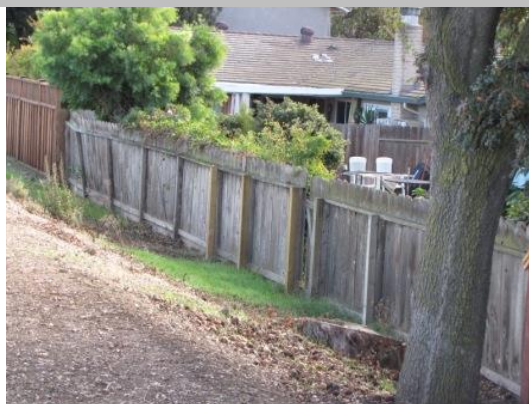
Photo 1 of 1 : FA_2017_NA0017_152_13_20170921_00004.jpg

LM Start	3.19	Rating **	N	Issue No.	13
LM End	3.19	Issue Type +	Ma	Location *	LS
Category	Earthen Levee			GPS Latitude/Longitude	
				Start	End
Item	Trim / Thin Trees			38.042676 °	38.042676 °
				-121.325694 °	-121.325694 °
DWR ID	DWR_NA0017_08_s_2012_13				
Comment Code					
T5 : Tree stumps.					
Inspector Comment

View of a stump on the landward slope looking upstream.

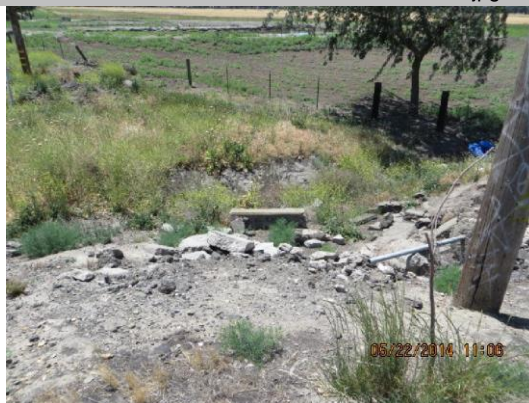
Photo 1 of 3 : UCIP_FA_2017_38510_70478.jpg

LM Start	3.65	Rating **	A/W	Issue No.	1127	
LM End	3.65	Issue Type +	Ma	Location *		
Category	Supplemental			GPS Latitude/Longitude		
				Start		End
Item	DWR UCIP LMA Responsibility			38.042660 °		38.042660 °
				-121.317222 °		-121.317222 °
DWR ID						
Comment Code						
Inspector Comment						
FS_ID:38510 DS_ID:23734 EP_NO: N/A Repair Type: No Action Needed Crossing Status: Found UCIP Comments: FIELD_STRUCT_DESC: 24-inch corrugated metal drainage pipe through the levee, 7.4 feet below the crown. Concrete U-shaped headwalls on both ends. Flap gate on the waterside (WS) end. Cobble grouted spillway across berm. [Additional Reference(s): DWR Levee Log, 1990. USACE San Joaquin O&M Manual 612.1, June 1965, (HLM 3.73)]. FS Date: 5/22/2014

Headwall at LS toe.

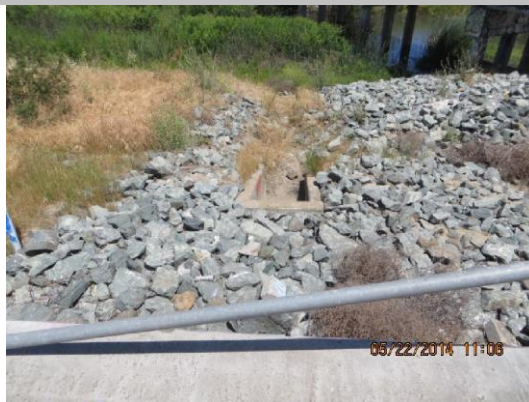
Photo 2 of 3 : UCIP_FA_2017_38510_70477.jpg

Headwall and flapgate at WS toe.

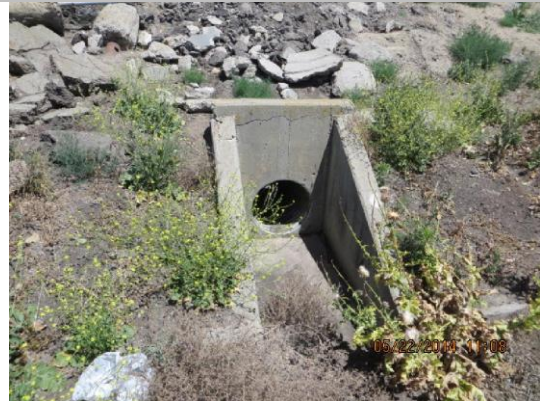
Photo 3 of 3 : UCIP_FA_2017_38510_70476.jpg

Headwall at LS toe.

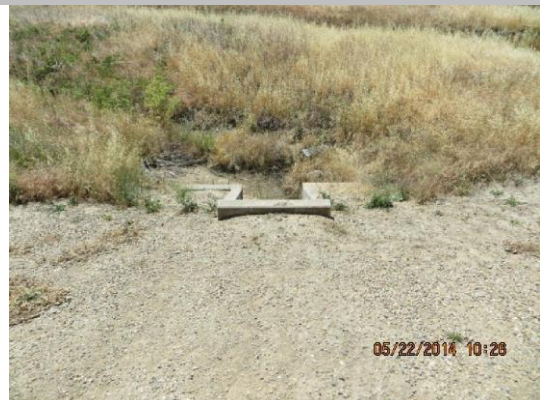
Photo 1 of 3 : UCIP_FA_2017_38477_70362.jpg

LM Start	4.55	Rating **	A/W	Issue No.	1131
LM End	4.55	Issue Type +	Ma	Location *	
Category	Supplemental			GPS Latitude/Longitude	
				Start	End
Item	DWR UCIP LMA Responsibility			38.042748 °	38.042748 °
				-121.300834 °	-121.300834 °
DWR ID					
Comment Code					
Inspector Comment					
FS_ID:38477					
DS_ID:23736					
EP_NO: N/A					
Repair Type: No Action Needed					
Crossing Status: Found					
UCIP Comments:					
FIELD_STRUCT_DESC: 36-inch corrugated metal storm drainage pipe through the levee, 9 feet below the crown. Concrete U-shaped shaped headwalls on both ends. Flap gate on the waterside (WS) end. Grouted intake on the landside (LS). Cobble grouted spillway across the berm. [Additional Reference(s): DWR Levee Log, 1990. USACE San Joaquin O&M Manual 612.1, June 1965, (HLM 4.65) and 612 (addendum), February 1999, (HLM 4.82) (Station 254+24)].					
FS Date: 5/22/2014

Headwall at LS toe.

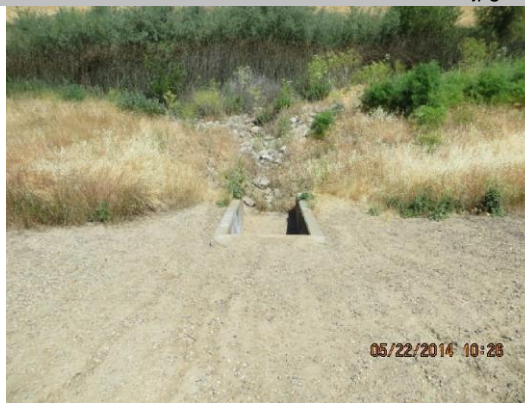
Photo 2 of 3 : UCIP_FA_2017_38477_70361.jpg

Item	DWR UCIP LMA Responsibility			38.042748 °		38.042748 °
				-121.300834 °		-121.300834 °
DWR ID						
Comment Code						
Inspector Comment						
FS_ID:38477						
DS_ID:23736						
EP_NO: N/A						
Repair Type: No Action Needed						
Crossing Status: Found						
UCIP Comments:						
FIELD_STRUCT_DESC: 36-inch corrugated metal storm drainage pipe through the levee, 9 feet below the crown. Concrete U-shaped shaped headwalls on both ends. Flap gate on the waterside (WS) end. Grouted intake on the landside (LS). Cobble grouted spillway across the berm. [Additional Reference(s): DWR Levee Log, 1990. USACE San Joaquin O&M Manual 612.1, June 1965, (HLM 4.65) and 612 (addendum), February 1999, (HLM 4.82) (Station 254+24)].						
FS Date: 5/22/2014

Headwall, flapgate, and grouted spillway on WS slope.

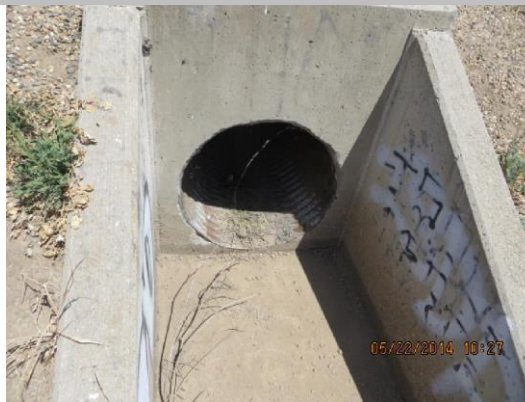
Photo 3 of 3 : UCIP_FA_2017_38477_70360.jpg

Headwall at LS toe.

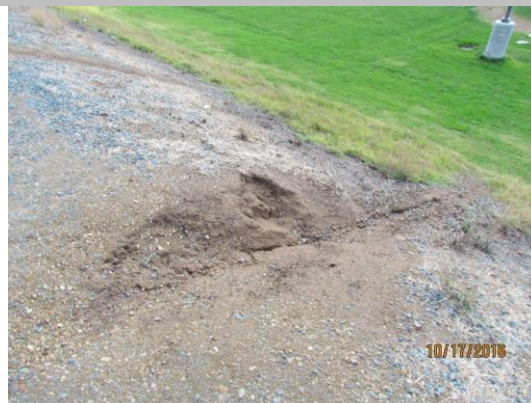
Photo 1 of 1 : FA_2017_NA0017_152_121_20170921_00032.jpg

LM Start	4.82	Rating **	M	Issue No.	121
LM End	4.82	Issue Type +	Ma	Location *	LS
Category	Earthen Levee			GPS Latitude/Longitude	
				Start	End
Item	Erosion / Bank Caving			38.043928 °	38.043928 °
				-121.296386 °	-121.296386 °
DWR ID	DWR_NA0017_08_f_2016_121				
Comment Code					
E2 : Schedule repair of erosion site prior to the next inspection.					
Inspector Comment					
Runoff

View of an erosion due to runoff on the land side slope of the levee.

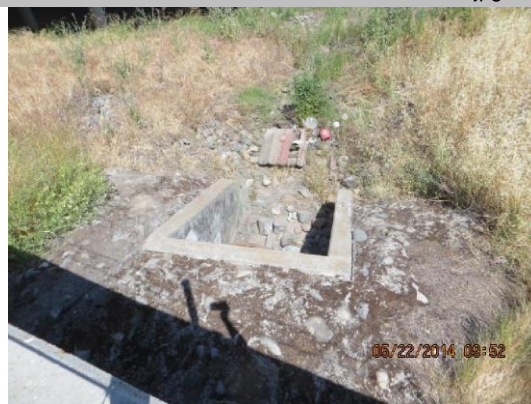
Photo 1 of 3 : UCIP_FA_2017_38447_70301.jpg

Comment Code					
Inspector Comment					
FS_ID:38447					
DS_ID:23739					
EP_NO: 16684D					
Repair Type: No Action Needed					
Crossing Status: Found					
UCIP Comments:					
FIELD_STRUCT_DESC: 24-inch corrugated metal storm drainage pipe through the levee, 9.3 feet below the crown. 30-inch concrete inlet on the landside (LS) toe. Concrete U-shaped headwalls on both ends. Flap gate on the waterside (WS) end. Grouted intake on the LS. Cobble grouted spillway across berm. (Permit No. 16684-D, 1997, and Permit No. 16566-A, 1996 - San Joaquin County Flood Control Agency). [Additional Reference(s): DWR Levee Log, 1990. USACE San Joaquin O&M Manual 612.1, June 1965, (HLM 5.01) and 612 (addendum), February 1999, (HLM 5.16) (Station 272+55)].					
FS Date: 5/22/2014

Headwall and flapgate at WS slope.

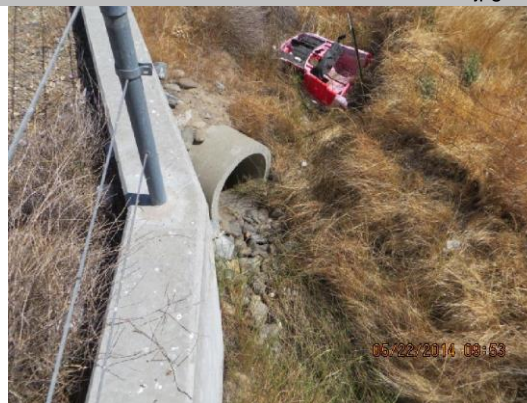
Photo 2 of 3 : UCIP_FA_2017_38447_70300.jpg

30-inch concrete inlet pipe at LS toe.

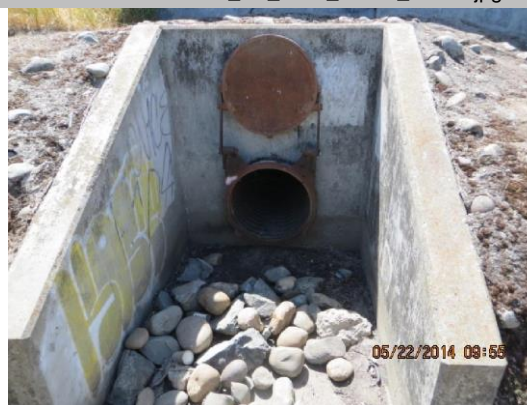
Photo 3 of 3 : UCIP_FA_2017_38447_70299.jpg

Headwall and flapgate on WS toe.

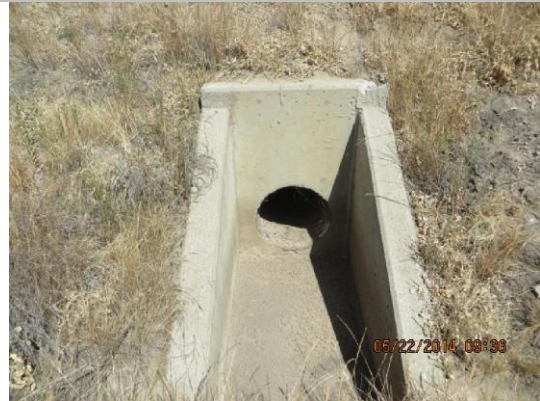
Photo 3 of 3 : UCIP_FA_2017_38444_70289.jpg

LM Start	5.56	Rating **	A/W	Issue No.	1134 (cont)
LM End	5.56	Issue Type +	Ma	Location *	
Category	Supplemental			GPS Latitude/Longitude	
				Start	End
Item	DWR UCIP LMA Responsibility			38.050122 °	38.050122 °
				-121.286318 °	-121.286318 °
DWR ID					
Comment Code					
Inspector Comment					
FS_ID:38444 DS_ID:23709 EP_NO: N/A Repair Type: No Action Needed Crossing Status: Found UCIP Comments: FIELD_STRUCT_DESC: 24-inch corrugated metal storm drainage pipe through the levee, 6.9 feet below the crown. Concrete U-shaped headwalls on both ends. Flap gate on the waterside (WS) end. Grouted intake on the landside (LS). Cobble grouted spillway across the berm. [Additional Reference(s): DWR Levee Log, 1990. USACE San Joaquin O&M Manual 612.1, June 1965, (HLM 5.69) and 612 (addendum), February 1999, (HLM 5.82) (Station 307+37)]. FS Date: 5/22/2014

Headwall on LS toe.

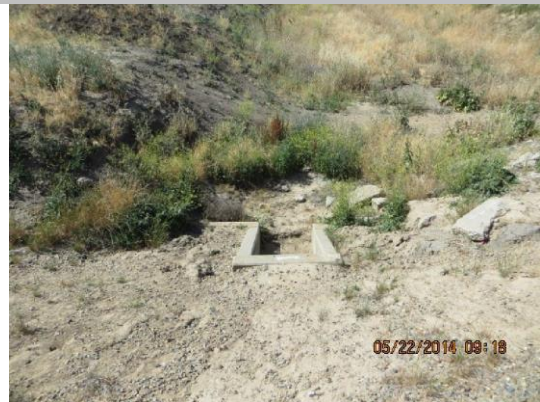
Photo 1 of 3 : UCIP_FA_2017_38427_70280.jpg

LM Start	6.10	Rating **	A/W	Issue No.	1136
LM End	6.10	Issue Type +	Ma	Location *	
Category	Supplemental			GPS Latitude/Longitude	
				Start	End
Item	DWR UCIP LMA Responsibility			38.052226 °	38.052226 °
				-121.277229 °	-121.277229 °
DWR ID					
Comment Code					
Inspector Comment					
FS_ID:38427					
DS_ID:23711					
EP_NO: N/A					
Repair Type: No Action Needed					
Crossing Status: Found					
UCIP Comments:					
FIELD_STRUCT_DESC: 24-inch corrugated metal drainage pipe through the levee, 7.3 feet below the crown. Concrete U-shaped headwalls on both ends. Flap gate on the waterside (WS) end. Grouted intake on the landside (LS). Cobble grouted spillway across berm. [Additional Reference(s): DWR Levee Log, 1990. USACE San Joaquin O&M Manual 612.1, June 1965, (HLM 6.25)].					
FS Date: 5/22/2014

Headwall on LS toe.

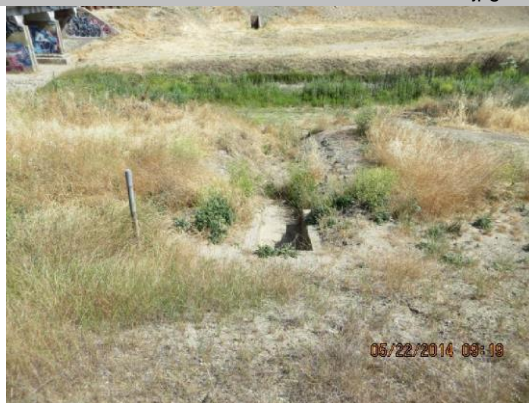
Photo 2 of 3 : UCIP_FA_2017_38427_70279.jpg

Headwall, flapgate, and grouted spillway on WS toe.

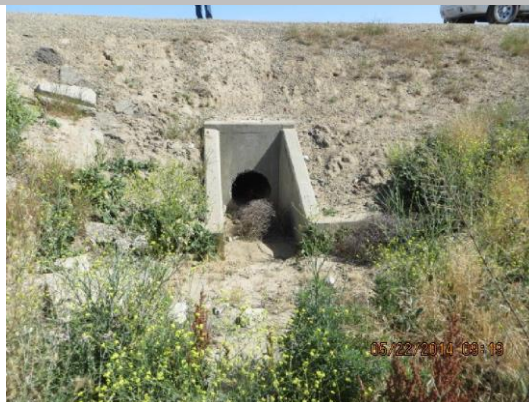
Photo 3 of 3 : UCIP_FA_2017_38427_70278.jpg

Headwall on LS toe.

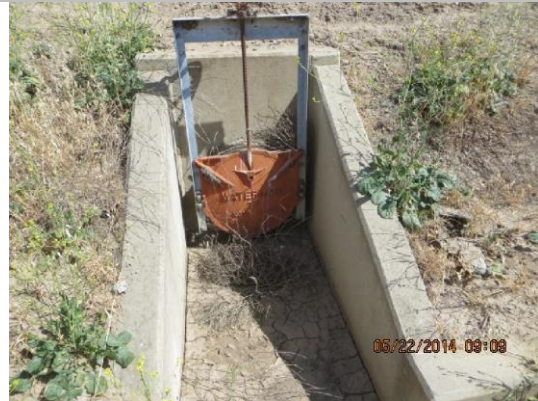
Photo 3 of 3 : UCIP_FA_2017_38373_70036.jpg

LM Start	6.20	Rating **	M	Issue No.	1138 (cont)
LM End	6.20	Issue Type +	Ma	Location *	
Category	Supplemental			GPS Latitude/Longitude	
				Start	End
Item	DWR UCIP LMA Responsibility			38.052247 °	38.052247 °
				-121.275311 °	-121.275311 °
DWR ID					
Comment Code					
Inspector Comment					
FS_ID:38373 DS_ID:23713 EP_NO: N/A Repair Type: Non-Urgent Crossing Status: Found UCIP Comments: Gate rusted shut on LS toe. FIELD_STRUCT_DESC: 24-inch corrugated metal storm drainage pipe through the levee, 7.9 feet below the crown. Concrete U-shaped headwalls on both ends. Flap gate on the waterside (WS) end. Slide gate on the landside (LS) end. Cobble grouted spillway across berm. [Additional Reference(s): DWR Levee Log, 1990. USACE San Joaquin O&M Manual 612.1, June 1965, (HLM 6.35) and 612 (addendum), February 1999, (HLM 6.36) (Station 335+70)]. FS Date: 5/22/2014

Slide gate on headwall at LS toe.

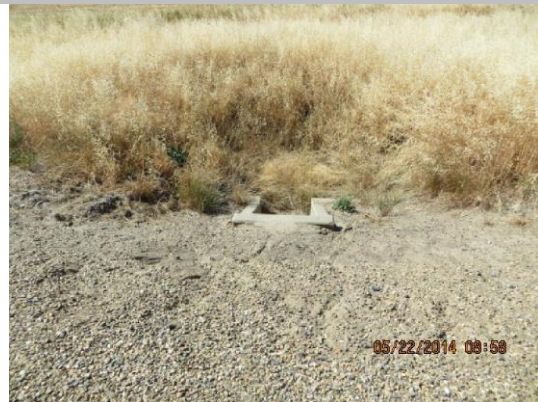
Photo 1 of 3 : UCIP_FA_2017_38368_70029.jpg

LM Start	6.41	Rating **	A/W	Issue No.	1139	
LM End	6.41	Issue Type +	Ma	Location *		
Category	Supplemental			GPS Latitude/Longitude		
				Start	End	
Item	DWR UCIP LMA Responsibility			38.053016 °	38.053016 °	
				-121.271705 °	-121.271705 °	
DWR ID						
Comment Code						
Inspector Comment						
FS_ID:38368						
DS_ID:23714						
EP_NO: N/A						
Repair Type: No Action Needed						
Crossing Status: Found						
UCIP Comments:						
FIELD_STRUCT_DESC: 24-inch corrugated metal drainage pipe through the levee, 8.5 feet below the crown. Concrete U-shaped headwalls on both ends. Flap gate on the waterside (WS) end. Grouted intake on the landside (LS). Cobble grouted spillway across the berm. [Additional Reference(s): DWR Levee Log, 1990. USACE San Joaquin O&M Manual 612.1, June 1965, (HLM 6.56)].						
FS Date: 5/22/2014

Headwall on LS toe.

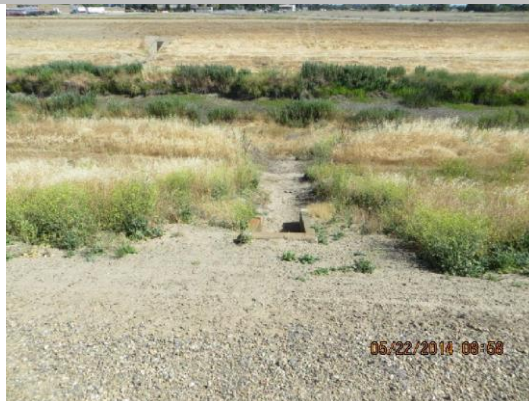
Photo 2 of 3 : UCIP_FA_2017_38368_70028.jpg

Headwall, flapgate, and grouted spillway on WS toe.

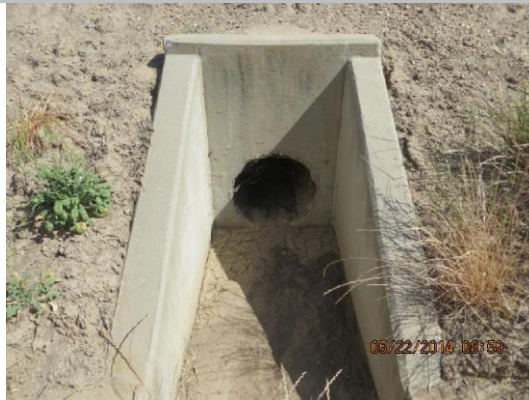
Photo 3 of 3 : UCIP_FA_2017_38368_70027.jpg

Headwall on LS toe.

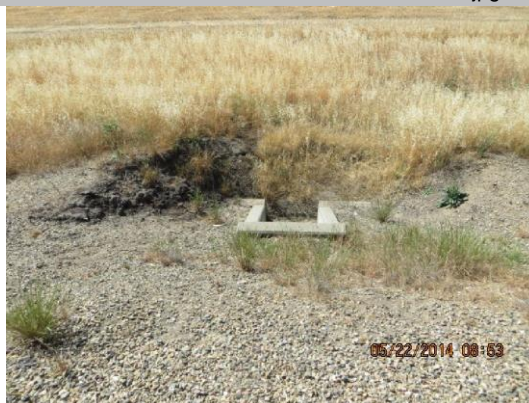
Photo 1 of 3 : UCIP_FA_2017_38367_70024.jpg

LM Start	6.56	Rating **	A/W	Issue No.	1140
LM End	6.56	Issue Type +	Ma	Location *	
Category	Supplemental			GPS Latitude/Longitude	
				Start	End
Item	DWR UCIP LMA Responsibility			38.053277 °	38.053277 °
				-121.268962 °	-121.268962 °
DWR ID					
Comment Code					
Inspector Comment					
FS_ID:38367					
DS_ID:23715					
EP_NO: N/A					
Repair Type: No Action Needed					
Crossing Status: Found					
UCIP Comments:					
FIELD_STRUCT_DESC: 24-inch corrugated metal storm drainage pipe through the levee, 8 feet below the crown. Concrete U-shaped headwalls on both ends. Flap gate on the waterside (WS) end. Grouted intake on the landside (LS). Cobble grouted spillway across the berm. [Additional Reference(s): DWR Levee Log, 1990. USACE San Joaquin O&M Manual 612.1, June 1965, (HLM 6.72) and 612 (addendum), February 1999, (HLM 6.67) (Station 352+14)].					
FS Date: 5/22/2014

Headwall on LS toe.

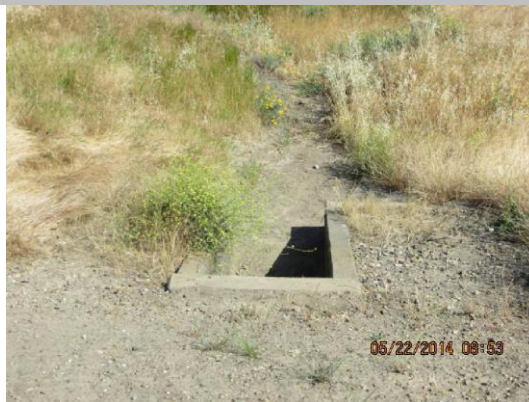
Photo 2 of 3 : UCIP_FA_2017_38367_70023.jpg

Headwall, flapgate, and grouted spillway on WS toe.

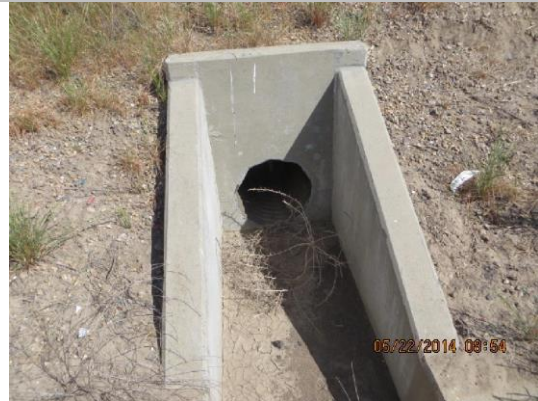
Photo 3 of 3 : UCIP_FA_2017_38367_70022.jpg

Headwall on LS toe.

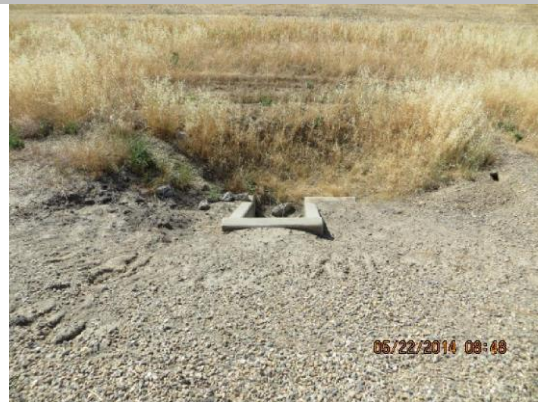
Photo 1 of 3 : UCIP_FA_2017_38365_70019.jpg

Headwall on LS toe.

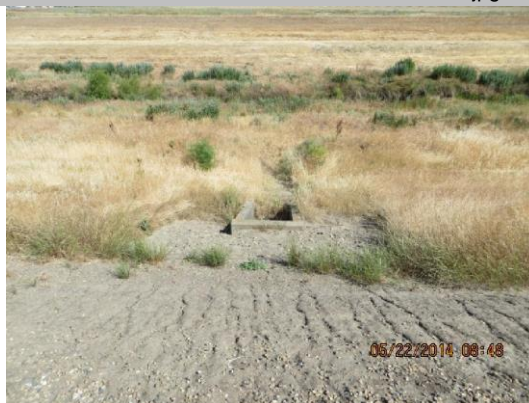
Photo 2 of 3 : UCIP_FA_2017_38365_70018.jpg

Headwall, flapgate, and grouted spillway on WS toe.

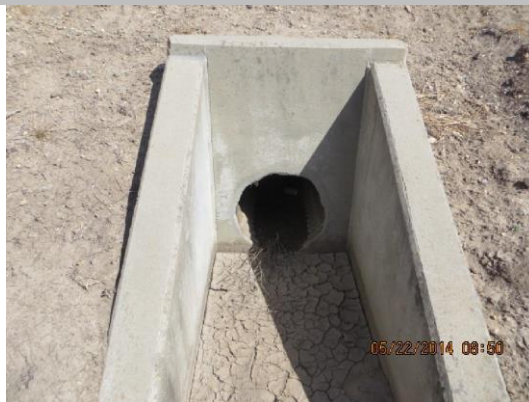
Photo 3 of 3 : UCIP_FA_2017_38365_70017.jpg

Headwall on LS toe.

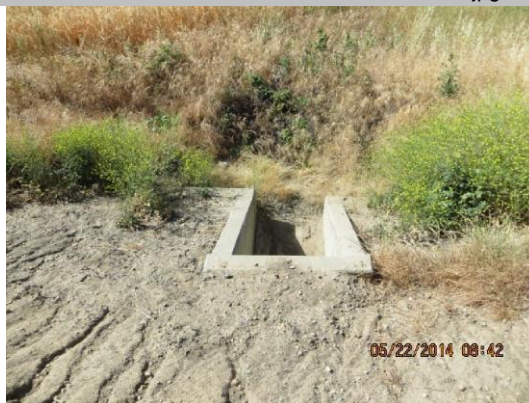
Photo 1 of 3 : UCIP_FA_2017_38363_70010.jpg

Headwall on LS toe.

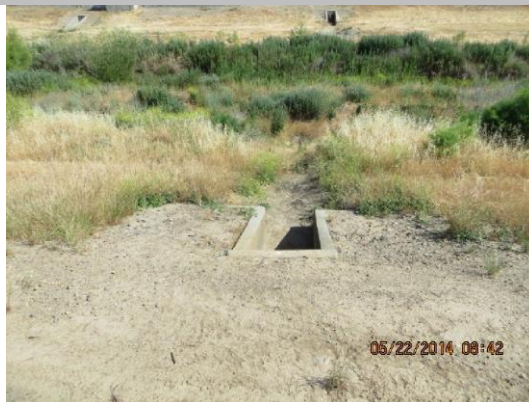
Photo 2 of 3 : UCIP_FA_2017_38363_70009.jpg

Headwall, flapgate, and grouted spillway on WS toe.

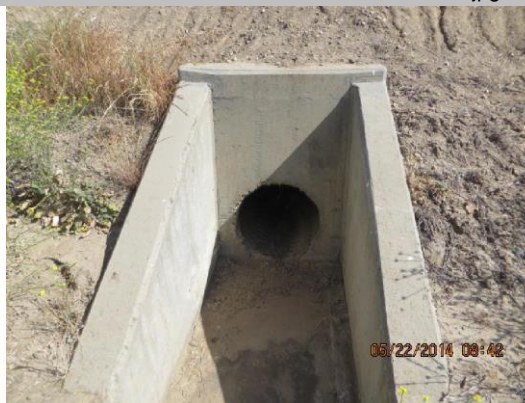
Photo 3 of 3 : UCIP_FA_2017_38363_70008.jpg

Headwall on LS toe.

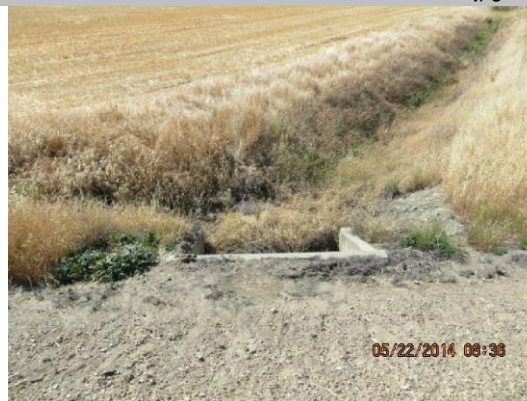
Photo 1 of 3 : UCIP_FA_2017_38361_70005.jpg

Headwall on LS toe.

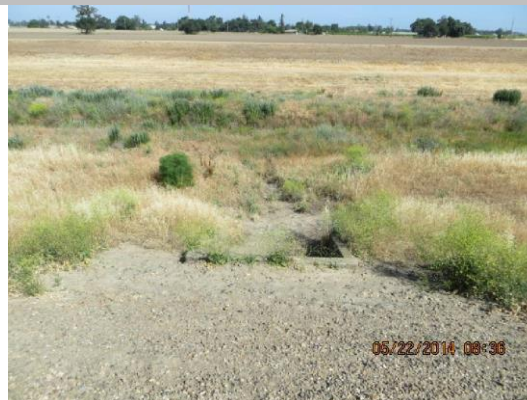
Photo 2 of 3 : UCIP_FA_2017_38361_70004.jpg

Headwall, flapgate, and grouted spillway on WS toe.

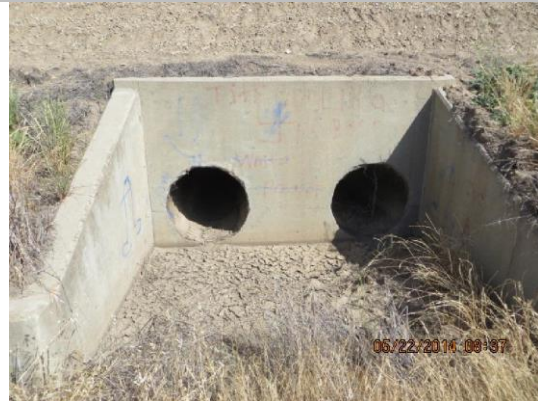
Photo 3 of 3 : UCIP_FA_2017_38361_70003.jpg

Headwall on LS toe.

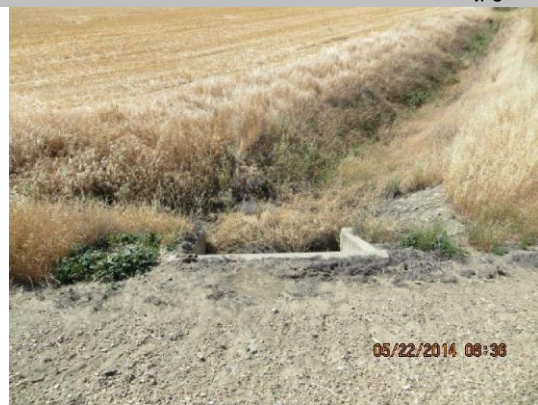
Photo 1 of 3 : UCIP_FA_2017_38360_70000.jpg

Headwall at LS toe.

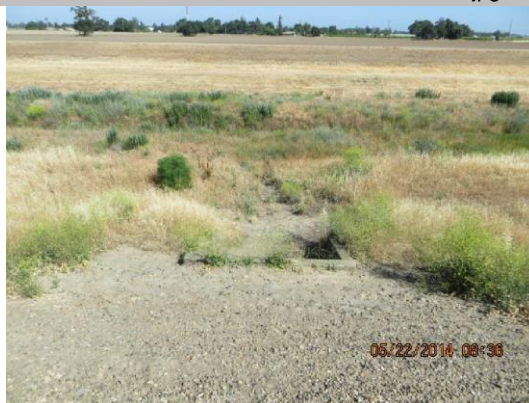
Photo 2 of 3 : UCIP_FA_2017_38360_69999.jpg

Headwall, flapgate, and grouted spillway on WS slope.

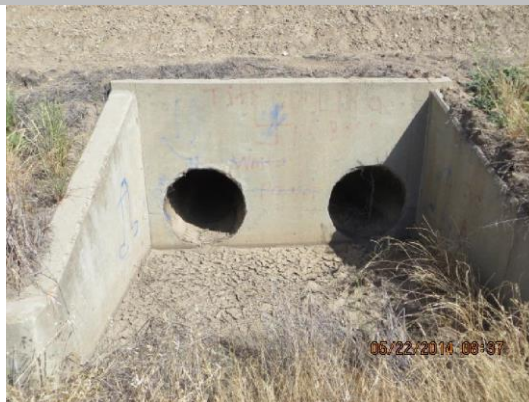
Photo 3 of 3 : UCIP_FA_2017_38360_69998.jpg

Headwall on LS toe.

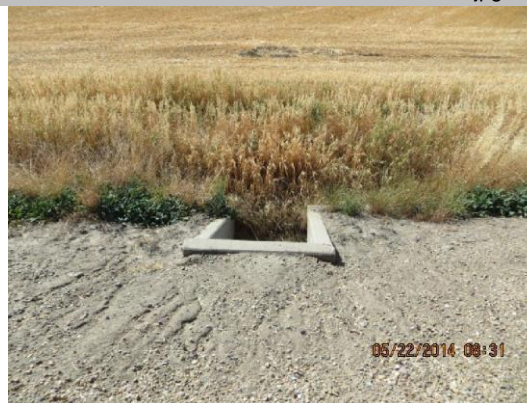
Photo 1 of 3 : UCIP_FA_2017_38359_69995.jpg

Headwall on LS toe.

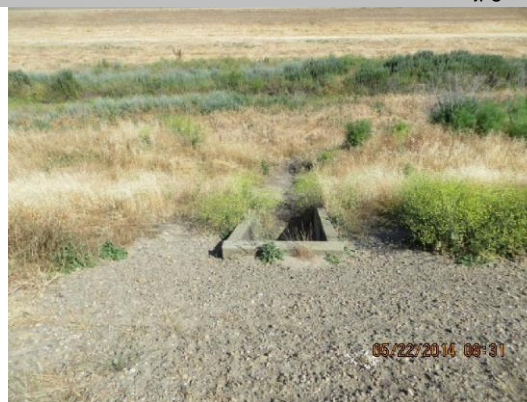
Photo 2 of 3 : UCIP_FA_2017_38359_69994.jpg

Headwall, flapgate, and grouted spillway on WS toe.

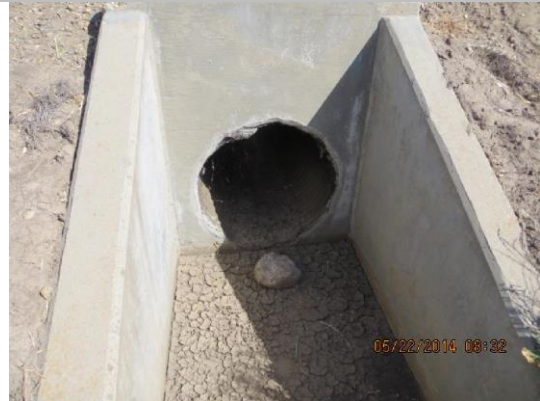
Photo 3 of 3 : UCIP_FA_2017_38359_69993.jpg

Headwall on LS toe.

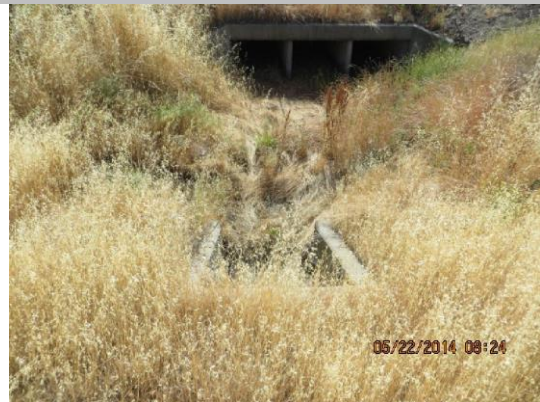
Photo 1 of 3 : UCIP_FA_2017_38358_69990.jpg

Headwall on LS toe.

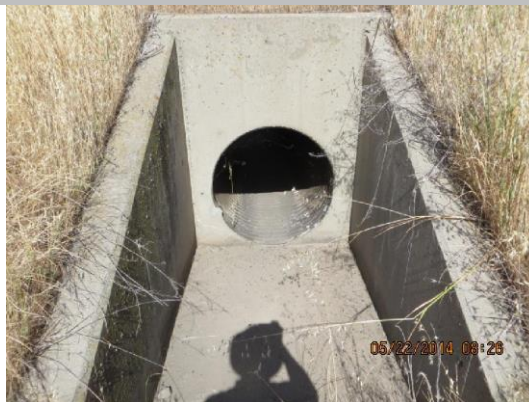
Photo 3 of 3 : UCIP_FA_2017_38358_69988.jpg

Headwall on LS toe.

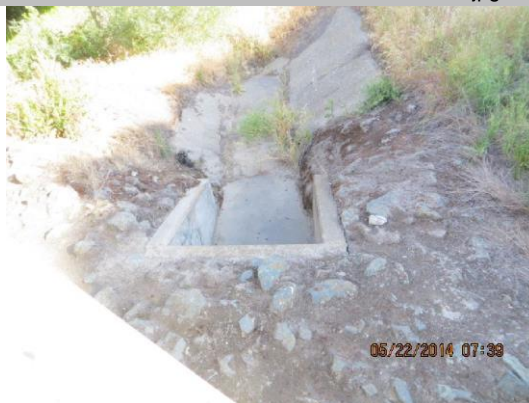
Photo 1 of 3 : UCIP_FA_2017_38354_69985.jpg

Headwall, flapgate, and grouted spillway on WS slope.

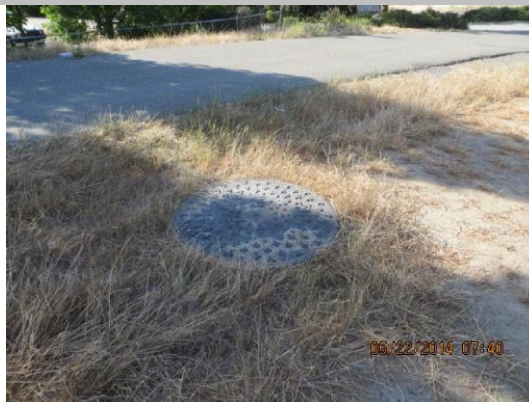
Photo 2 of 3 : UCIP_FA_2017_38354_69984.jpg

40-inch manhole on WS of crown.

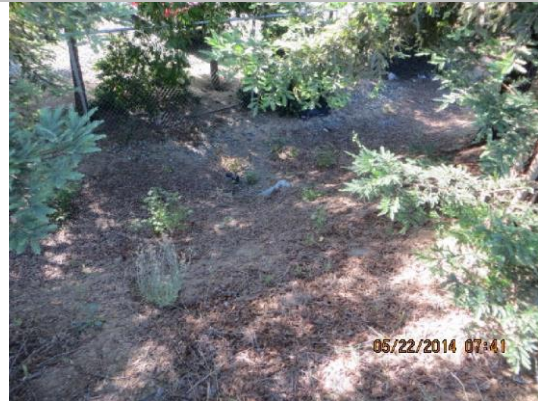
Photo 3 of 3 : UCIP_FA_2017_38354_69983.jpg

18-inch CMP inlet on LS toe.

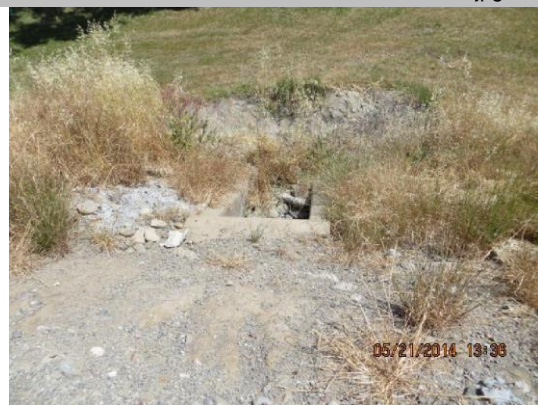
Photo 1 of 3 : UCIP_FA_2017_41809_69980.jpg

Comment Code						
Inspector Comment						
FS_ID:41809 DS_ID:23743 EP_NO: N/A Repair Type: Non-Urgent Crossing Status: Found UCIP Comments: Cobbles building up at inlet and inside pipe along with sediment. FIELD_STRUCT_DESC: 24-inch corrugated metal storm drainage pipe through the levee, 7 feet below the crown. Flap gate on the waterside (WS) end. Concrete U-shaped headwalls on both ends. Cobble grouted spillway across the berm. Cobble grouted apron on the landside (LS) end. [Additional Reference(s): DWR Levee Log, 1990. USACE San Joaquin O&M Manual 612.2, 1967, (HLM 7.65) and 612 (addendum), February 1999, (HLM 7.70) (Station 406+58)]. FS Date: 5/21/2014

Concrete headwall on LS toe.

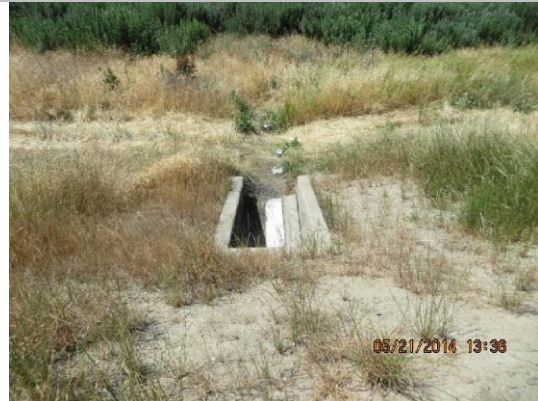
Photo 2 of 3 : UCIP_FA_2017_41809_69979.jpg

Concrete headwall and flapgate at WS toe.

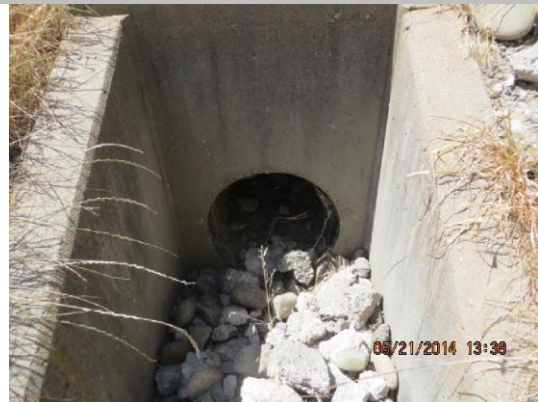
Photo 3 of 3 : UCIP_FA_2017_41809_69978.jpg

FS_ID:41809
DS_ID:23743
EP_NO: N/A
Repair Type: Non-Urgent
Crossing Status: Found
UCIP Comments: Cobbles building up at inlet and inside pipe along with sediment.
FIELD_STRUCT_DESC: 24-inch corrugated metal storm drainage pipe through the levee, 7 feet below the crown. Flap gate on the waterside (WS) end. Concrete U-shaped headwalls on both ends. Cobble grouted spillway across the berm. Cobble grouted apron on the landside (LS) end. [Additional Reference(s): DWR Levee Log, 1990. USACE San Joaquin O&M Manual 612.2, 1967, (HLM 7.65) and 612 (addendum), February 1999, (HLM 7.70) (Station 406+58)].
FS Date: 5/21/2014

Concrete headwall on LS toe. Cobbles distributed at inlet.

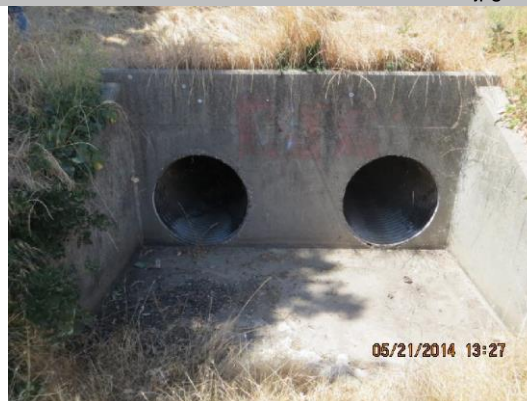
Photo 3 of 3 : UCIP_FA_2017_38352_69972.jpg

Comment Code						
Inspector Comment						
FS_ID:38352						
DS_ID:23744						
EP_NO: N/A						
Repair Type: Non-Urgent						
Crossing Status: Found						
UCIP Comments: Lid damaged/missing from CMP riser on WS slope.						
FIELD_STRUCT_DESC: 1 of 2: 36-inch corrugated metal storm						
drainage pipe through the levee, 9 feet below the crown. Flap gate on						
the waterside (WS) end. Slide gate in 48-inch corrugated metal riser						
unit on the WS slope. Concrete U-shaped headwalls on both ends.						
Cobble grouted spillway on the channel bank. Cobble grouted apron in						
ditch on the landside (LS). [Additional Reference(s): DWR Levee Log,						
1990. USACE San Joaquin O&M Manual 612.2, 1967, (HLM 8.18) and						
612 (addendum), February 1999, (HLM 8.21) (Station 433+70)].						
FS Date: 5/21/2014

Headwall at drainage channel on LS toe.

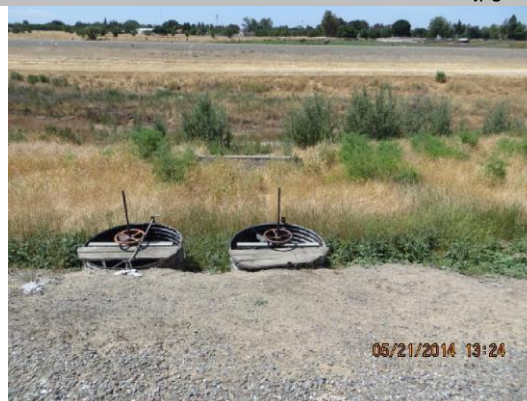
Photo 1 of 3 : UCIP_FA_2017_38351_69968.jpg

FS_ID:38351
DS_ID:23820
EP_NO: N/A
Repair Type: Non-Urgent
Crossing Status: Found
UCIP Comments: Lid damaged/missing on 48-inch CMP riser on WS slope.
FIELD_STRUCT_DESC: 2 of 2: 36-inch corrugated metal storm drainage pipe through the levee, 9 feet below the crown. Flap gate on the waterside (WS) end. Slide gate in corrugated metal riser units on the WS slope. Concrete U-shaped headwalls on both ends. Cobble grouted spillway on the channel bank. Cobble grouted apron in ditch on the landside (LS). [Additional Reference(s): DWR Levee Log, 1990. USACE San Joaquin O&M Manual 612.2, 1967, (HLM 8.18) and 612 (addendum), February 1999, (HLM 8.21) (Station 433+70)].
FS Date: 5/21/2014

Slide gate in 48-inch CMP riser on WS slope. Note the missing lid material.

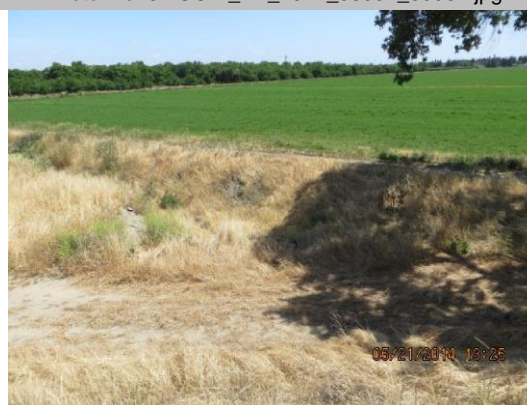
Photo 2 of 3 : UCIP_FA_2017_38351_69967.jpg

Headwall on LS toe at drainage channel.

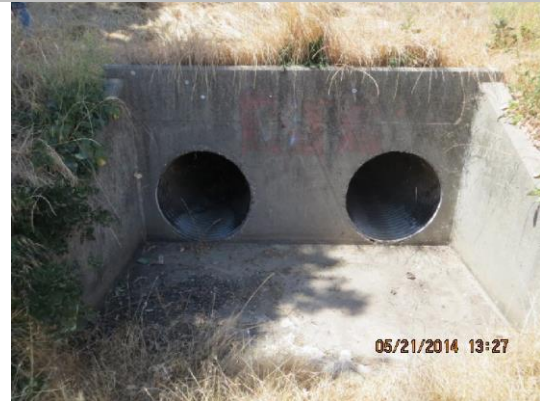
Photo 3 of 3 : UCIP_FA_2017_38351_69966.jpg

Headwall on LS toe at drainage channel.

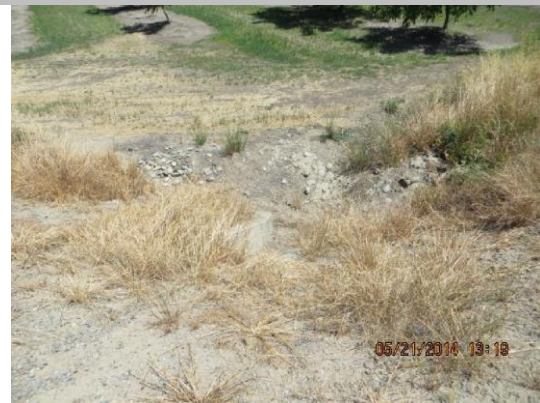
Photo 1 of 3 : UCIP_FA_2017_38350_69963.jpg

Headwall and grouted apron on LS toe.

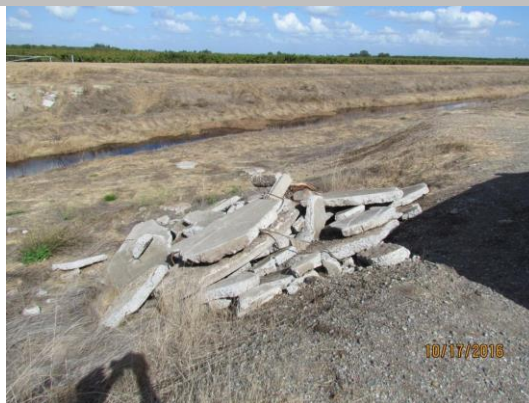
Photo 1 of 1 : FA_2017_NA0017_152_126_20170921_00036.jpg

LM Start	8.43	Rating **	M	Issue No.	126
LM End	8.43	Issue Type +	Ma	Location *	WS
Category	Earthen Levee			GPS Latitude/Longitude	
				Start	End
Item	Encroachments			38.066939 °	38.066939 °
				-121.242196 °	-121.242196 °
DWR ID	DWR_NA0017_08_f_2016_126				
Comment Code					
DE : Debris					
Inspector Comment					
Concrete Debris

View of concrete debris on the waterside of the levee. Fall 2016.
