**Flood Control Project Maintenance
Levee Inspections**

Maintenance Issue Types Only, Levee Inspection Report By Mile - Fall 2017

San Joaquin County Flood Control and Water Conservation District

Waterway	Bank	Unit Miles	Inspection Start/End	Inspector
Unit No. 01 Littlejohn Creek	Left	2.59	10/17/2017 10/17/2017	Pavel Kazi

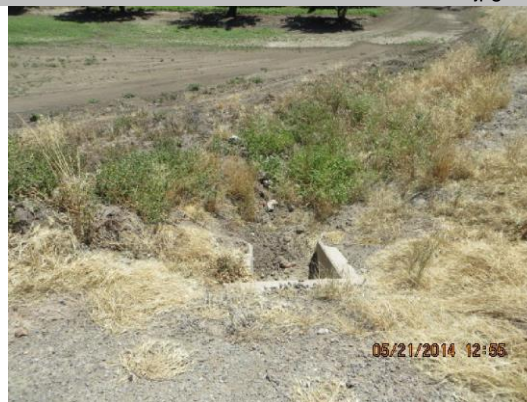
Photo 1 of 3 : UCIP_FA_2017_38346_69954.jpg

Headwall at LS toe.

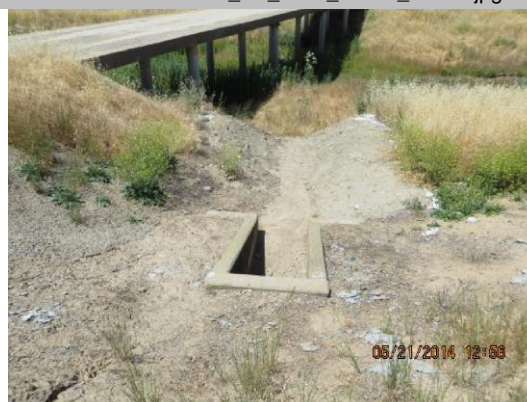
Photo 2 of 3 : UCIP_FA_2017_38346_69953.jpg

Headwall, flapgate, and grouted spillway on WS slope.

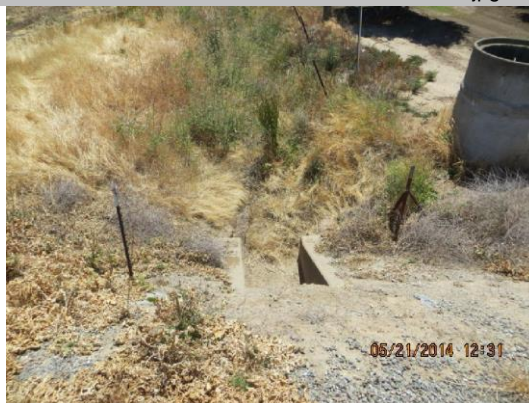
Photo 2 of 3 : UCIP_FA_2017_38241_69738.jpg

Headwall at LS toe.

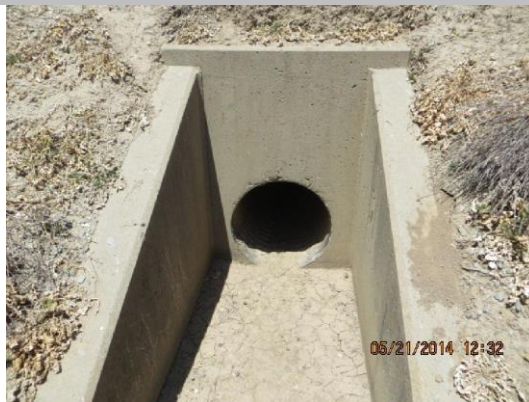
Photo 3 of 3 : UCIP_FA_2017_38241_69737.jpg

Headwall at LS toe.

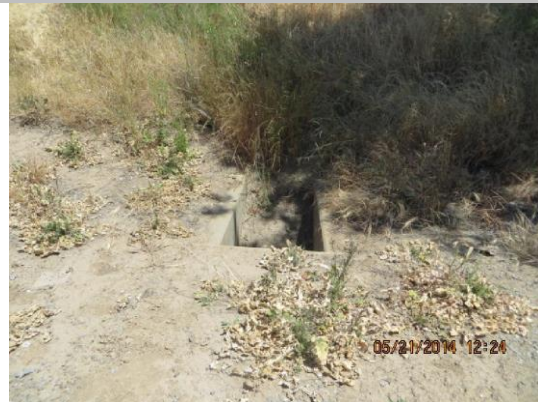
Photo 1 of 3 : UCIP_FA_2017_38239_69728.jpg

Headwall at LS toe.

Comment Code					
Inspector Comment					
FS_ID:38239 DS_ID:23727 EP_NO: N/A Repair Type: Non-Urgent Crossing Status: Found UCIP Comments: Sediment and debris buildup inside pipe on LS toe. FIELD_STRUCT_DESC: 24-inch corrugated metal storm drainage pipe through the levee, 7 feet below the crown. Flap gate on the waterside (WS) end. Concrete U-shaped headwalls on both ends. Cobble grouted spillway across the berm. Cobble grouted apron on the landside (LS) end. [Additional Reference(s): DWR Levee Log, 1990. USACE San Joaquin O&M Manual 612.2, 1967, (HLM 10.09) and 612 (addendum), February 1999, (HLM 10.00) (Station 528+18)]. FS Date: 5/21/2014

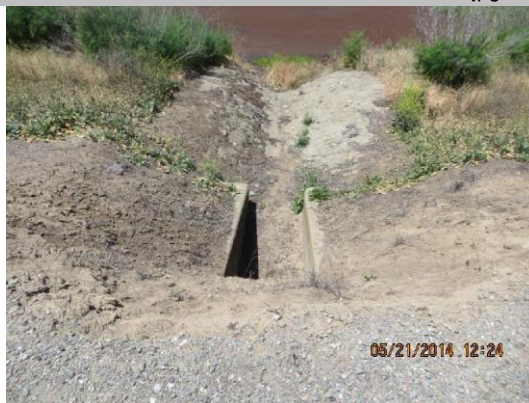
Photo 2 of 3 : UCIP_FA_2017_38239_69727.jpg

Headwall, flapgate, and grouted spillway on WS slope.

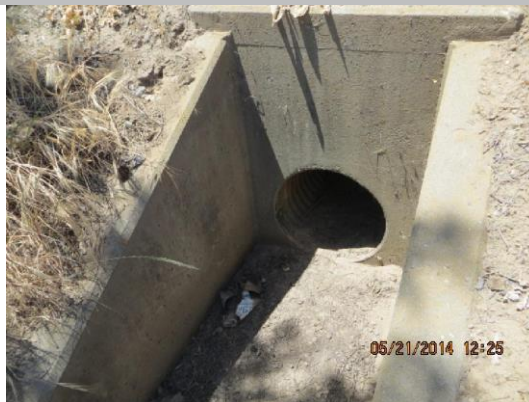
Photo 3 of 3 : UCIP_FA_2017_38239_69726.jpg

Headwall at LS toe.

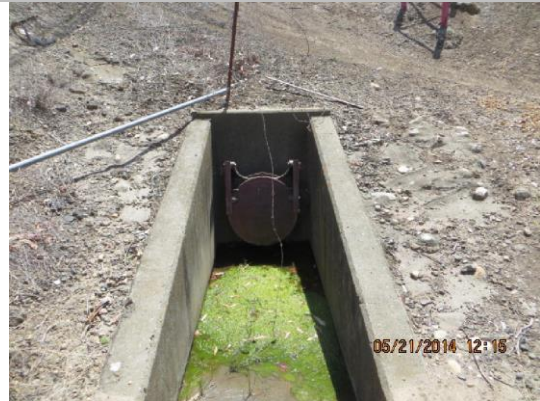
Photo 3 of 3 : UCIP_FA_2017_38232_69704.jpg

Headwall and flapgate on WS slope.

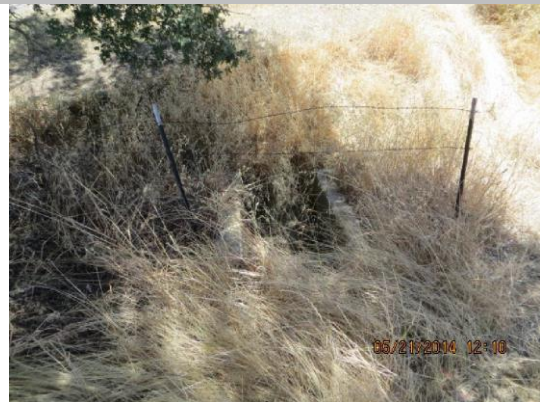
Photo 1 of 3 : UCIP_FA_2017_41808_69701.jpg

Comment Code						
Inspector Comment						
FS_ID:41808 DS_ID:23729 EP_NO: N/A Repair Type: Non-Urgent Crossing Status: Found UCIP Comments: Some sediment buildup in pipe at LS toe. FIELD_STRUCT_DESC: 24-inch corrugated metal storm drainage pipe through the levee, 7 feet below the crown. Flap gate on the waterside (WS) end. Concrete U-shaped headwalls on both ends. Cobble grouted spillway across the berm. Cobble grouted apron on the landside (LS) end. [Additional Reference(s): DWR Levee Log, 1990. USACE San Joaquin O&M Manual 612.2, 1967, (HLM 10.48) and 612 (addendum), February 1999, (HLM 10.46) (Station 552+17)]. FS Date: 5/21/2014

Headwall at LS toe.

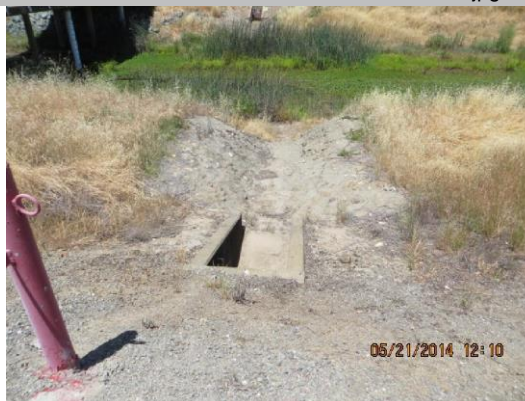
Photo 2 of 3 : UCIP_FA_2017_41808_69700.jpg

Headwall, flapgate, and grouted spillway on WS slope.

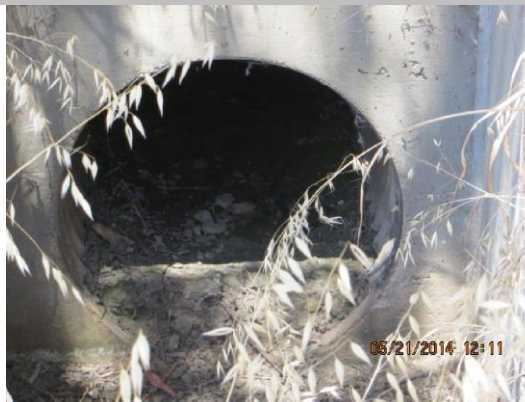
Photo 3 of 3 : UCIP_FA_2017_41808_69703.jpg

Headwall at LS toe.

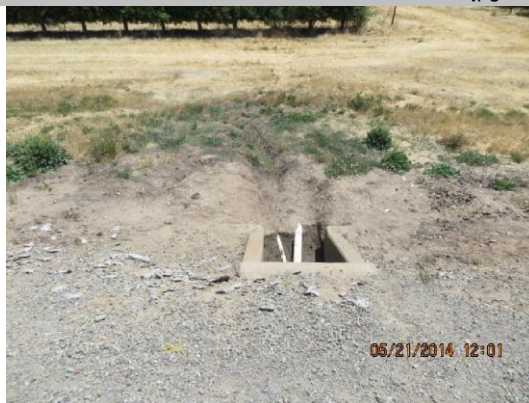
Photo 1 of 3 : UCIP_FA_2017_38229_69693.jpg

Comment Code					
Inspector Comment					
FS_ID:38229 DS_ID:23748 EP_NO: N/A Repair Type: No Action Needed Crossing Status: Found UCIP Comments: 2-small PVC pipes discharge into inlet on LS toe. FIELD_STRUCT_DESC: 24-inch corrugated metal storm drainage pipe through the levee, 7 feet below the crown. Flap gate on the waterside (WS) end. Concrete U-shaped headwalls on both ends. Cobble grouted spillway across the berm. Cobble grouted apron on the landside (LS) end. [Additional Reference(s): DWR Levee Log, 1990. USACE San Joaquin O&M Manual 612.2, 1967, (HLM 10.75) and 612 (addendum), February 1999, (HLM 10.72) (Station 566+09)]. FS Date: 5/21/2014

Headwall with two PVC discharge pipes at LS toe.

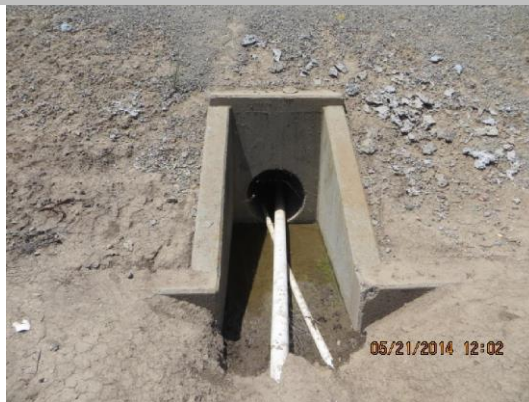
Photo 2 of 3 : UCIP_FA_2017_38229_69692.jpg

Headwall with two PVC discharge pipes at LS toe.

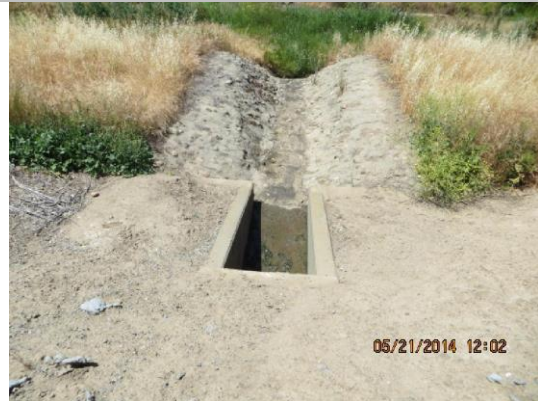
Photo 3 of 3 : UCIP_FA_2017_38229_69691.jpg

Headwall, flapgate, and grouted spillway on WS slope.

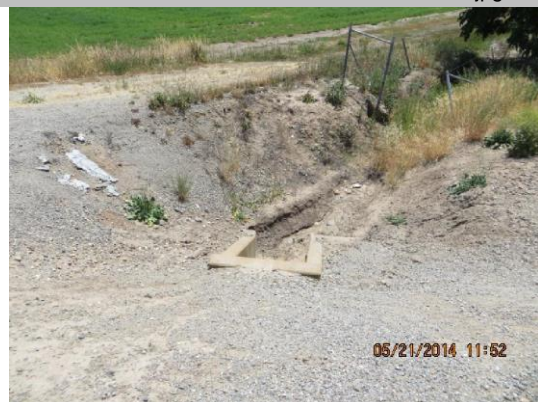
Photo 1 of 3 : UCIP_FA_2017_41810_69684.jpg

Headwall at LS toe.

Item	DWR UCIP LMA Responsibility			38.078140 °		38.078140 °
				-121.205820 °		-121.205820 °
DWR ID						
Comment Code						
Inspector Comment						
FS_ID:41810 DS_ID:23749 EP_NO: N/A Repair Type: Non-Urgent Crossing Status: Found UCIP Comments: Some silt buildup in pipe at LS toe. FIELD_STRUCT_DESC: 24-inch corrugated metal storm drainage pipe through the levee, 8 feet below the crown. Flap gate on the waterside (WS) end. Concrete U-shaped headwalls on both ends. Cobble grouted spillway across the berm. Cobble grouted apron on the landside (LS) end. [Additional Reference(s): DWR Levee Log, 1990. USACE San Joaquin O&M Manual 612.2, 1967, (HLM 10.97) and 612 (addendum), February 1999, (HLM 10.94) (Station 577+59)]. FS Date: 5/21/2014

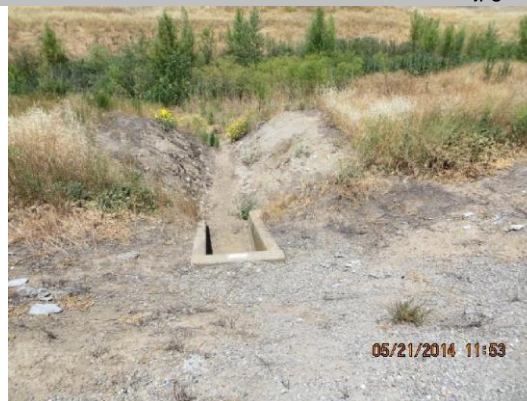
Photo 2 of 3 : UCIP_FA_2017_41810_69683.jpg

Headwall, flapgate, and grouted spillway on WS slope.

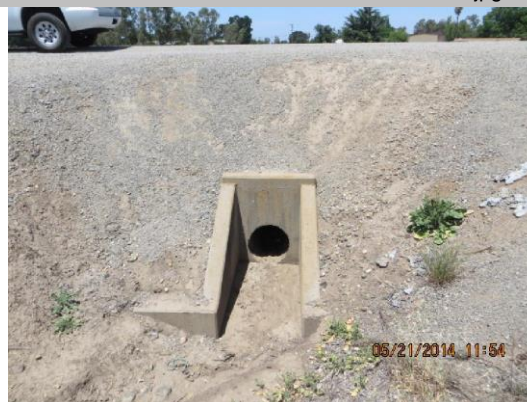
Photo 3 of 3 : UCIP_FA_2017_41810_69682.jpg

Headwall at LS toe.

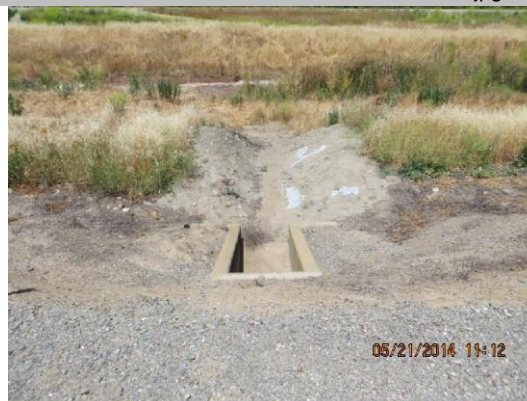
Photo 1 of 3 : UCIP_FA_2017_38224_69667.jpg

Headwall, flapgate, and grouted spillway on WS slope.

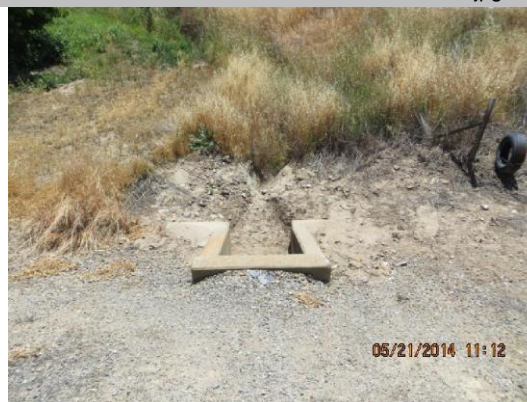
Photo 2 of 3 : UCIP_FA_2017_38224_69666.jpg

Headwall at LS toe.

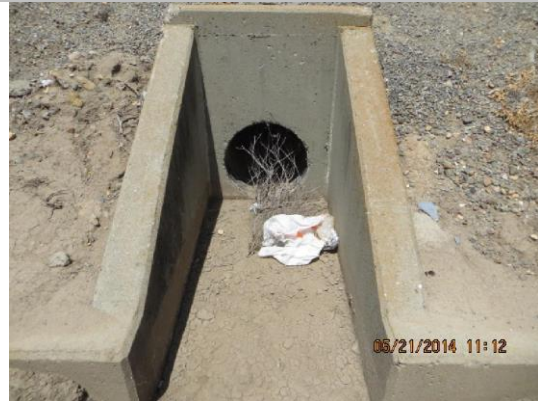
Photo 3 of 3 : UCIP_FA_2017_38224_69665.jpg

Headwall at LS toe.

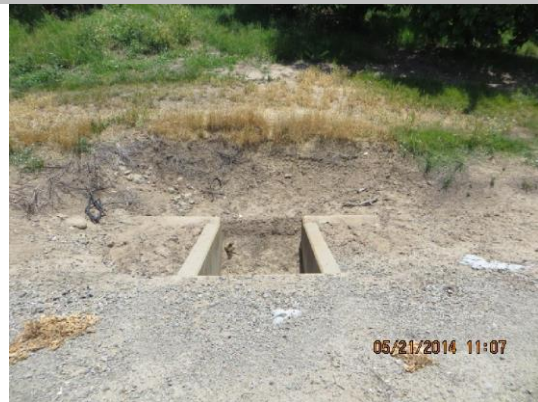
Photo 1 of 3 : UCIP_FA_2017_38223_69662.jpg

Headwall and grouted intake on LS toe.

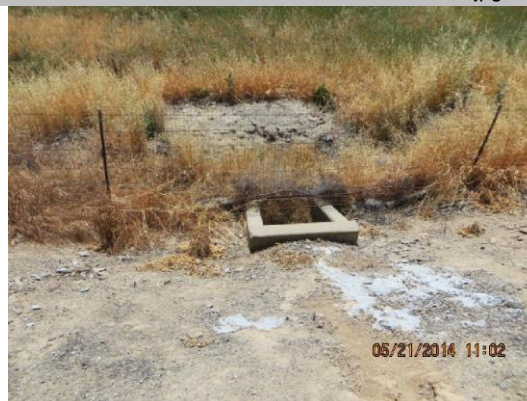
Photo 1 of 3 : UCIP_FA_2017_38221_69659.jpg

Headwall at LS toe with grouted inlet.

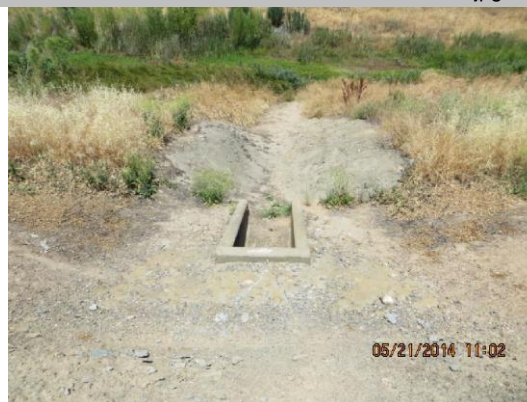
Photo 2 of 3 : UCIP_FA_2017_38221_69658.jpg

Headwall, flapgate, and grouted spillway on WS slope.

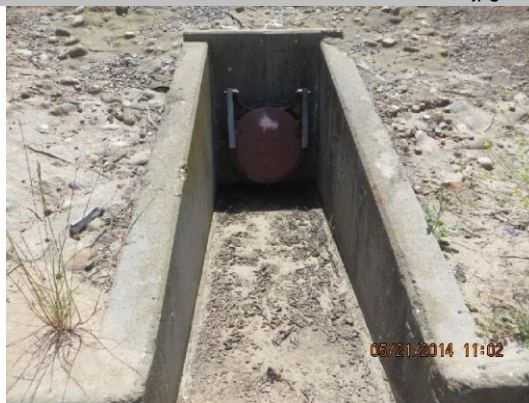
Photo 3 of 3 : UCIP_FA_2017_38221_69657.jpg

Headwall and flapgate on WS slope.

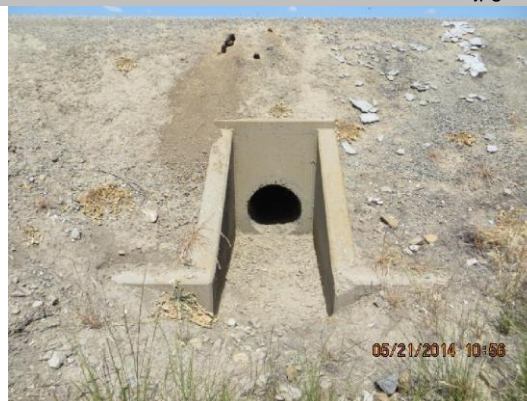
Photo 3 of 3 : UCIP_FA_2017_51700_69651.jpg

Headwall on LS toe.

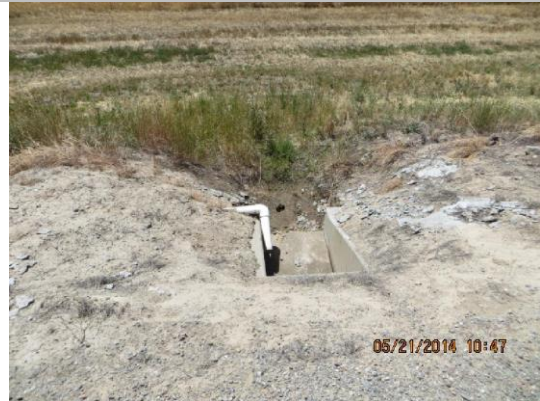
Photo 1 of 3 : UCIP_FA_2017_51701_69648.jpg

Headwall at LS toe. 4-inch PVC backwash from filter plant discharges at headwall.

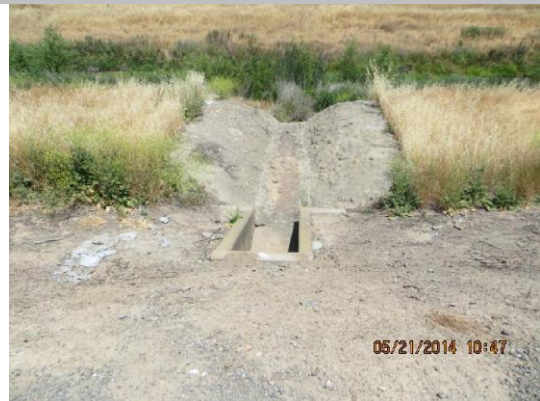
Photo 2 of 3 : UCIP_FA_2017_51701_69647.jpg

Headwall, flapgate, and grouted spillway on WS slope.

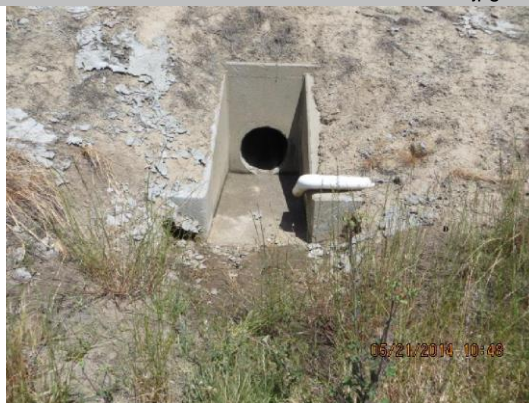
Photo 3 of 3 : UCIP_FA_2017_51701_69646.jpg

Headwall on LS toe.

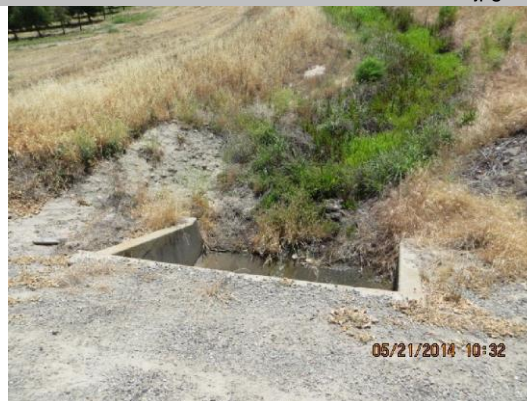
Photo 1 of 3 : UCIP_FA_2017_38216_69639.jpg

Headwall on LS toe.

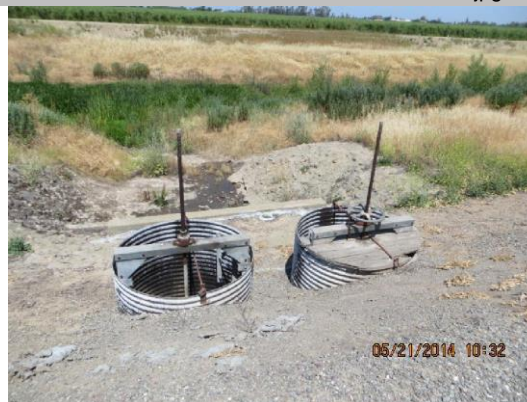
Photo 2 of 3 : UCIP_FA_2017_38216_69638.jpg

Comment Code					
Inspector Comment					
FS_ID:38216					
DS_ID:23756					
EP_NO: N/A					
Repair Type: Non-Urgent					
Crossing Status: Found					
UCIP Comments: CMP riser missing cover on WS slope.					
FIELD_STRUCT_DESC: 1 of 2: 48-inch corrugated metal storm drainage pipe through the levee, 8.5 feet below the crown. Slide gate in 60-inch corrugated metal riser unit on the waterside (WS) slope. Concrete U-shaped headwalls on both ends. Cobble grouted spillway on the WS end. Cobble grouted apron on the landside (LS) end.					
[Additional Reference(s): DWR Levee Log, 1990. USACE San Joaquin O&M Manual 612.2, 1967, (HLM 12.20) and 612 (addendum), February 1999, (HLM 12.13) (Station 640+50)].					
FS Date: 5/21/2014

Slide gate in CMP riser on WS slope missing cover.

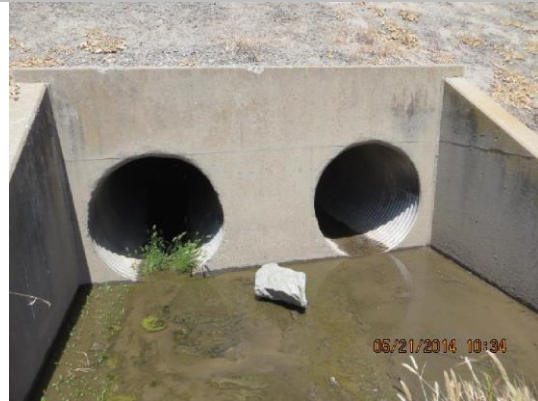
Photo 3 of 3 : UCIP_FA_2017_38216_69637.jpg

Headwall on LS toe.

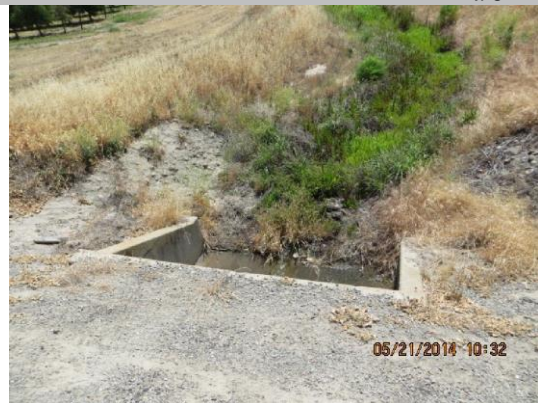
Photo 1 of 3 : UCIP_FA_2017_38214_69625.jpg

Headwall on LS toe.

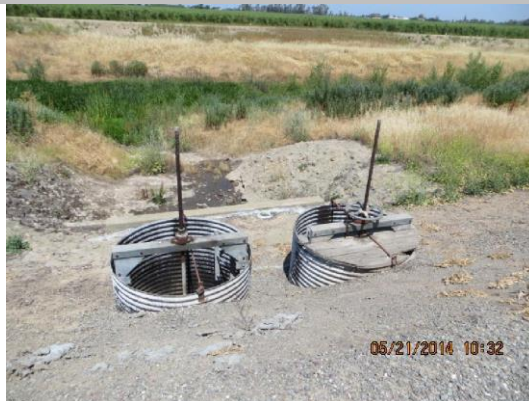
Photo 2 of 3 : UCIP_FA_2017_38214_69624.jpg

FS_ID:38214
DS_ID:23818
EP_NO: N/A
Repair Type: Non-Urgent
Crossing Status: Found
UCIP Comments: CMP riser missing cover on WS slope may be hazard.
FIELD_STRUCT_DESC: 2 of 2: 48-inch corrugated metal storm drainage pipe through the levee, 8.5 feet below the crown. Slide gate in 60-inch corrugated metal riser unit on the waterside (WS) slope. Concrete U-shaped headwalls on both ends. Cobble grouted spillway on the WS end. Cobble grouted apron on the landside (LS) end.
[Additional Reference(s): DWR Levee Log, 1990. USACE San Joaquin O&M Manual 612.2, 1967, (HLM 12.20) and 612 (addendum), February 1999, (HLM 12.13) (Station 640+50)].
FS Date: 5/21/2014

Slidegate on WS shoulder.

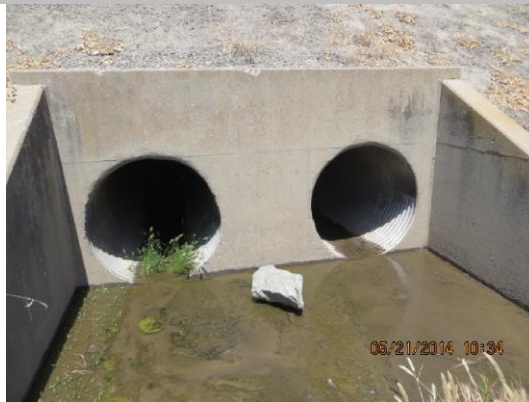
Photo 3 of 3 : UCIP_FA_2017_38214_69623.jpg

Headwall on LS toe.

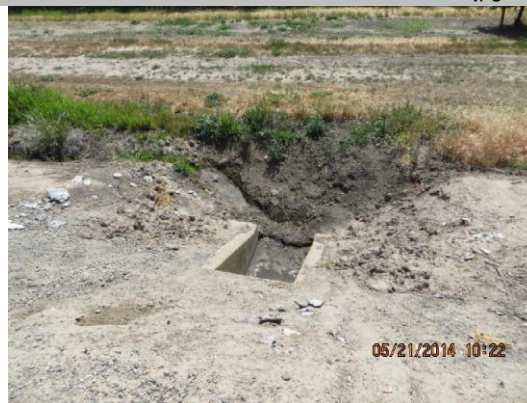
Photo 1 of 3 : UCIP_FA_2017_41811_69621.jpg

Headwall on LS toe.

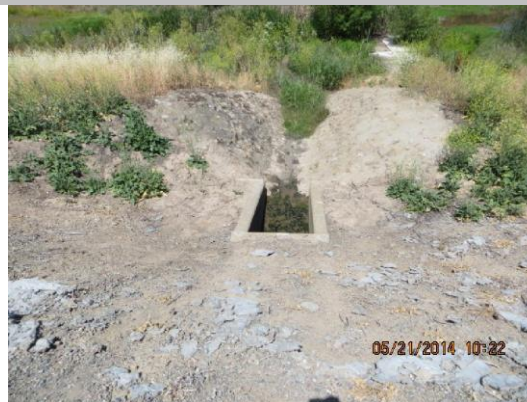
Photo 2 of 3 : UCIP_FA_2017_41811_69620.jpg

Headwall, flapgate, and grouted spillway on WS slope.

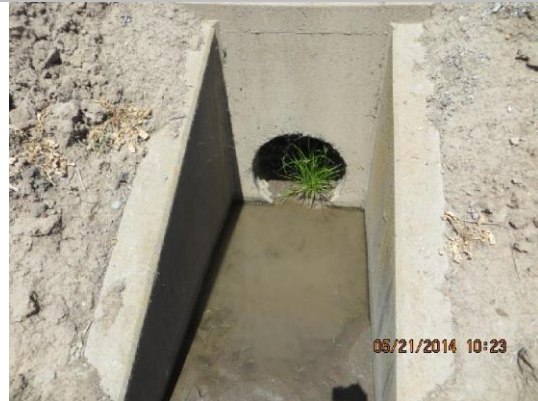
Photo 3 of 3 : UCIP_FA_2017_41811_69619.jpg

Headwall on LS toe.

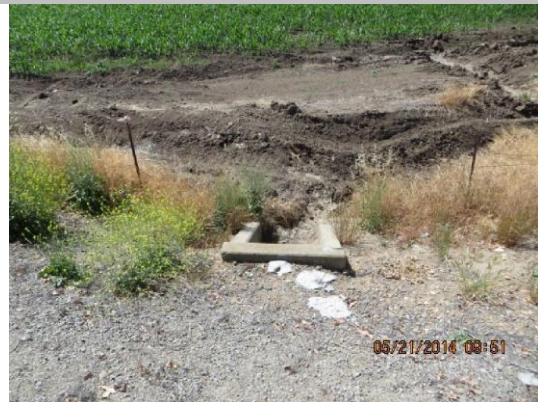
Photo 1 of 3 : UCIP_FA_2017_38210_69610.jpg

Headwall on LS toe.

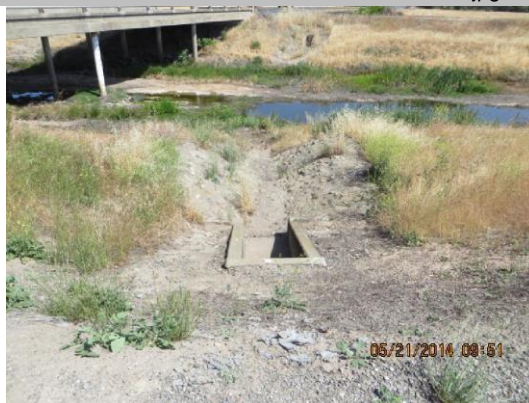
Photo 2 of 3 : UCIP_FA_2017_38210_69609.jpg

Headwall, flapgate, and grouted spillway on WS slope.

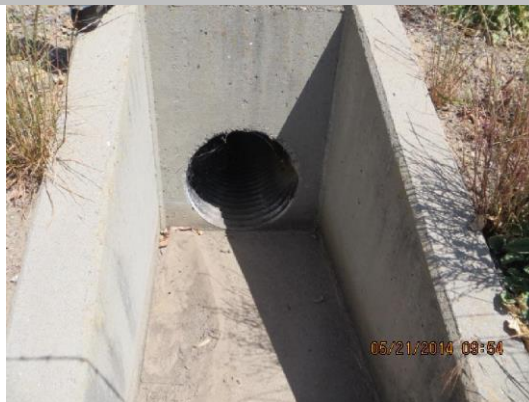
Photo 3 of 3 : UCIP_FA_2017_38210_69608.jpg

Headwall on LS toe.

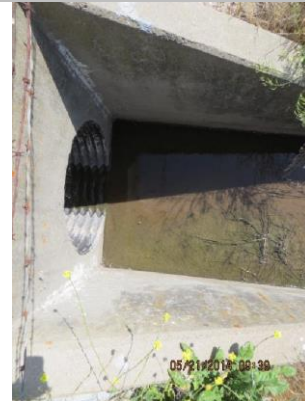
Photo 3 of 3 : UCIP_FA_2017_38206_69600.jpg

Headwall at LS toe.

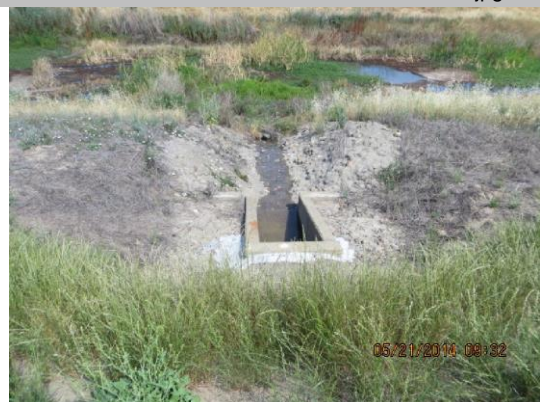
Photo 1 of 3 : UCIP_FA_2017_38205_69591.jpg

LM Start	12.63	Rating **	A/W	Issue No.	1178
LM End	12.63	Issue Type +	Ma	Location *	
Category	Supplemental			GPS Latitude/Longitude	
				Start	End
Item	DWR UCIP LMA Responsibility			38.092598 °	38.092598 °
				-121.177228 °	-121.177228 °
DWR ID					
Comment Code					
Inspector Comment					
FS_ID:38205 DS_ID:23765 EP_NO: N/A Repair Type: No Action Needed Crossing Status: Found UCIP Comments: FIELD_STRUCT_DESC: 24-inch corrugated metal drainage pipe through the levee, 9 feet below the crown. Flap gate on the waterside (WS) end. Slide gate on the landside (LS) end. Concrete U-shaped headwalls on both ends. Cobble grouted spillway across the berm. Cobble grouted apron on the LS end. [Additional Reference(s): DWR Levee Log, 1990. USACE San Joaquin O&M Manual 612.2, 1967, (HLM 13.00)]. FS Date: 5/21/2014

Headwall, flapgate, and grouted spillway on WS slope.

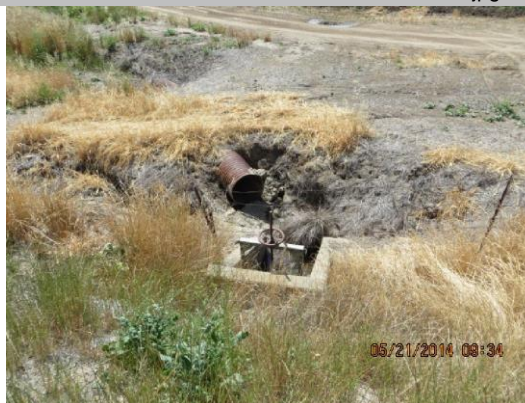
Photo 2 of 3 : UCIP_FA_2017_38205_69590.jpg

Headwall and Slidegate on LS toe.

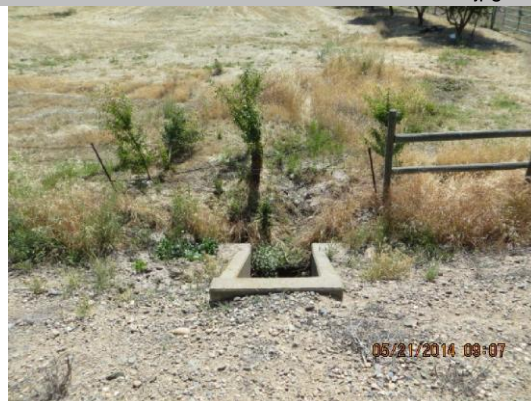
Photo 1 of 3 : UCIP_FA_2017_38203_69582.jpg

LM Start	12.89	Rating **	A/W	Issue No.	1180	
LM End	12.89	Issue Type +	Ma	Location *		
Category	Supplemental			GPS Latitude/Longitude		
				Start	End	
Item	DWR UCIP LMA Responsibility			38.097279 °	38.097279 °	
				-121.175854 °	-121.175854 °	
DWR ID						
Comment Code						
Inspector Comment						
FS_ID:38203 DS_ID:23767 EP_NO: N/A Repair Type: No Action Needed Crossing Status: Found UCIP Comments: FIELD_STRUCT_DESC: 24-inch corrugated metal drainage pipe through the levee, 7 feet below the crown. Concrete U-shaped headwall on both ends. Flap gate on the waterside (WS) end. Cobble grouted spillway. Cobble grouted intake on the landside (LS). [Additional Reference(s): DWR Levee Log, 1990. USACE San Joaquin O&M Manual 612.2, 1967, (HLM 13.26)]. FS Date: 5/21/2014

Concrete headwall on LS toe.

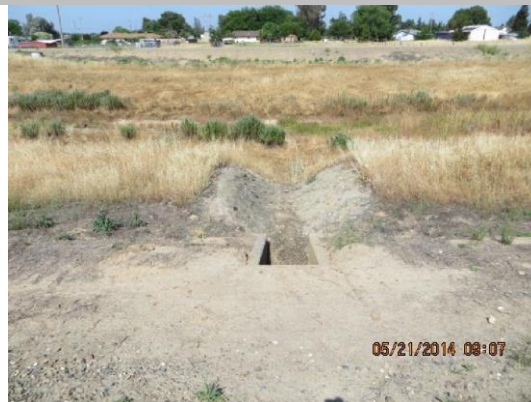
Photo 2 of 3 : UCIP_FA_2017_38203_69581.jpg

Headwall, flapgate, and grouted spillway on WS slope.

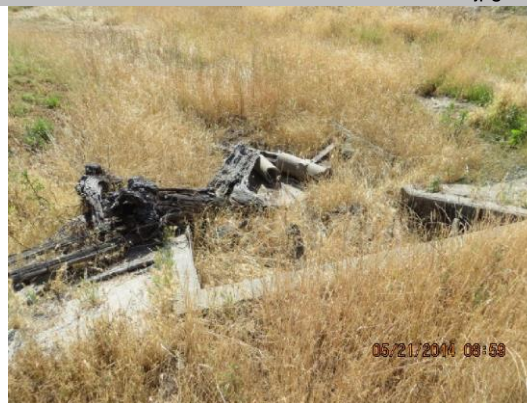
Photo 2 of 3 : UCIP_FA_2017_38144_69425.jpg

LM Start	12.98	Rating **	M	Issue No.	1181 (cont)	
LM End	12.98	Issue Type +	Ma	Location *		
Category	Supplemental			GPS Latitude/Longitude		
				Start		End
Item	DWR UCIP LMA Responsibility			38.098566 °	38.098566 °	
				-121.175704 °	-121.175704 °	
DWR ID						
Comment Code						
Inspector Comment						
FS_ID:38144 DS_ID:23768 EP_NO: N/A Repair Type: Non-Urgent Crossing Status: Found UCIP Comments: Some debris buildup at inlet. No lid on CMP riser on WS slope. FIELD_STRUCT_DESC: 1 of 2: 36-inch corrugated metal drainage pipe through the levee, 10 feet below the crown. Concrete U-shaped headwall on both ends. Slide gate in corrugated metal riser unit on the waterside (WS) slope. Flap gate on the WS end. [Additional Reference(s): DWR Levee Log, 1990. USACE San Joaquin O&M Manual 612.2, 1967, (HLM 13.35)]. FS Date: 5/21/2014

Headwall on LS toe. Note debris buildup.

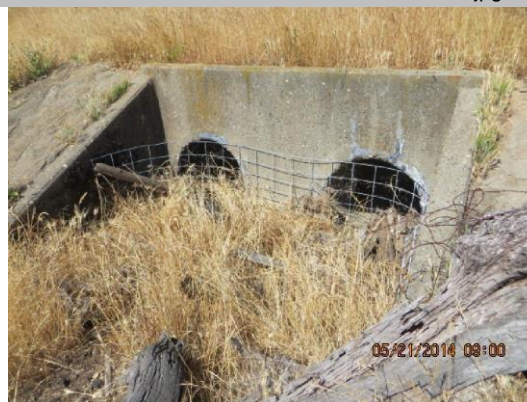
Photo 3 of 3 : UCIP_FA_2017_38144_69424.jpg

Headwall on LS toe. Note debris buildup.

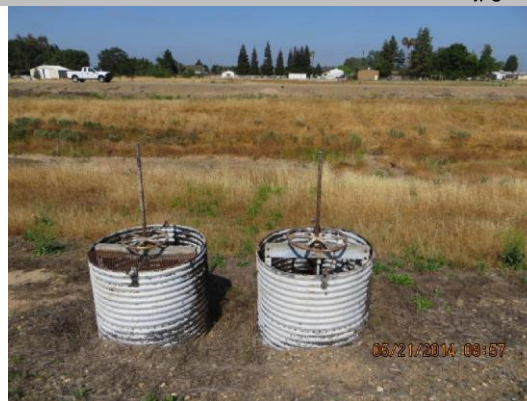
Photo 1 of 3 : UCIP_FA_2017_38143_69422.jpg

LM Start	12.98	Rating **	M	Issue No.	1182
LM End	12.98	Issue Type +	Ma	Location *	
Category	Supplemental			GPS Latitude/Longitude	
				Start	End
Item	DWR UCIP LMA Responsibility			38.098582 °	38.098582 °
				-121.175703 °	-121.175703 °
DWR ID					
Comment Code					
Inspector Comment					
FS_ID:38143 DS_ID:23816 EP_NO: N/A Repair Type: Non-Urgent Crossing Status: Found UCIP Comments: Some debris buildup at inlet and no lid on standpipe at WS shoulder. FIELD_STRUCT_DESC: 2 of 2: 36-inch corrugated metal drainage pipe through the levee, 10 feet below the crown. Concrete U-shaped headwall on both ends. Slide gate in corrugated metal riser unit on the waterside (WS) slope. Flap gate on the WS end. [Additional Reference(s): DWR Levee Log, 1990. USACE San Joaquin O&M Manual 612.2, 1967, (HLM 13.35)]. FS Date: 5/21/2014

Slide gate in CMP riser on WS slope.

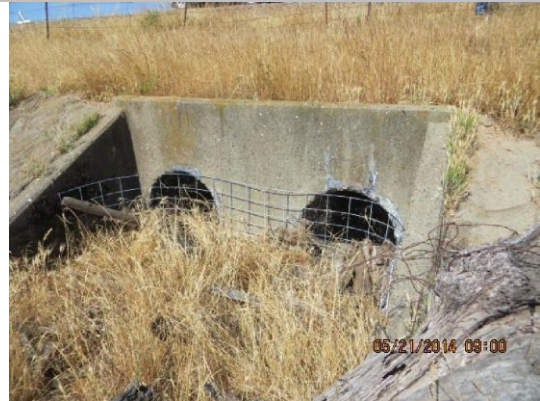
Photo 3 of 3 : UCIP_FA_2017_38143_69420.jpg

LM Start	12.98	Rating **	M	Issue No.	1182 (cont)
LM End	12.98	Issue Type +	Ma	Location *	
Category	Supplemental			GPS Latitude/Longitude	
				Start	End
Item	DWR UCIP LMA Responsibility			38.098582 °	38.098582 °
				-121.175703 °	-121.175703 °
DWR ID					
Comment Code					
Inspector Comment					
FS_ID:38143 DS_ID:23816 EP_NO: N/A Repair Type: Non-Urgent Crossing Status: Found UCIP Comments: Some debris buildup at inlet and no lid on standpipe at WS shoulder. FIELD_STRUCT_DESC: 2 of 2: 36-inch corrugated metal drainage pipe through the levee, 10 feet below the crown. Concrete U-shaped headwall on both ends. Slide gate in corrugated metal riser unit on the waterside (WS) slope. Flap gate on the WS end. [Additional Reference(s): DWR Levee Log, 1990. USACE San Joaquin O&M Manual 612.2, 1967, (HLM 13.35)]. FS Date: 5/21/2014

Headwall on LS toe. Note debris buildup.

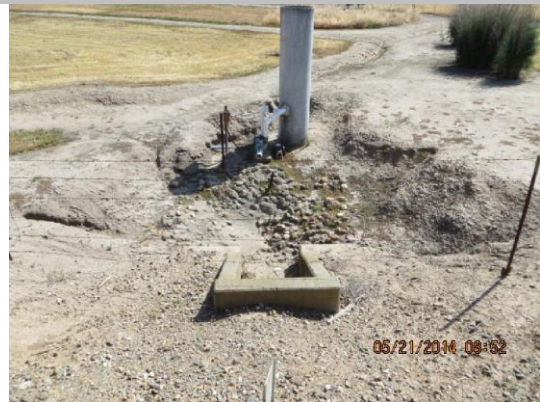
Photo 1 of 3 : UCIP_FA_2017_38141_69418.jpg

LM Start	13.13	Rating **	A/W	Issue No.	1183
LM End	13.13	Issue Type +	Ma	Location *	
Category	Supplemental			GPS Latitude/Longitude	
				Start	End
Item	DWR UCIP LMA Responsibility			38.100544 °	38.100544 °
				-121.176536 °	-121.176536 °
DWR ID					
Comment Code					
Inspector Comment					
FS_ID:38141 DS_ID:23769 EP_NO: N/A Repair Type: No Action Needed Crossing Status: Found UCIP Comments: FIELD_STRUCT_DESC: 24-inch corrugated metal drainage pipe through the levee, 8 feet below the crown. Concrete U-shaped headwall on both ends. Flap gate on the waterside (WS) end. Cobble grouted spillway. Cobble grouted intake on the landside (LS). [Additional Reference(s): DWR Levee Log, 1990. USACE San Joaquin O&M Manual 612.2, 1967, (HLM 13.50)]. FS Date: 5/21/2014

Headwall on LS toe.

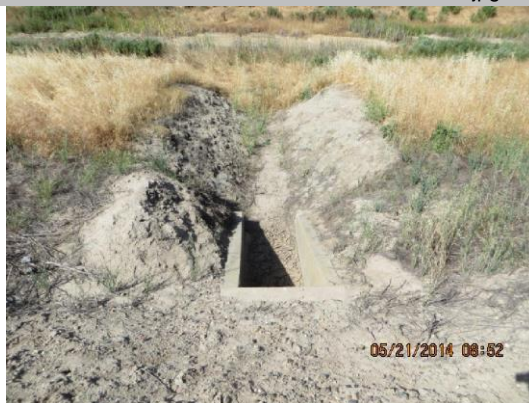
Photo 2 of 3 : UCIP_FA_2017_38141_69417.jpg

Headwall, flapgate, and grouted spillway on WS slope.

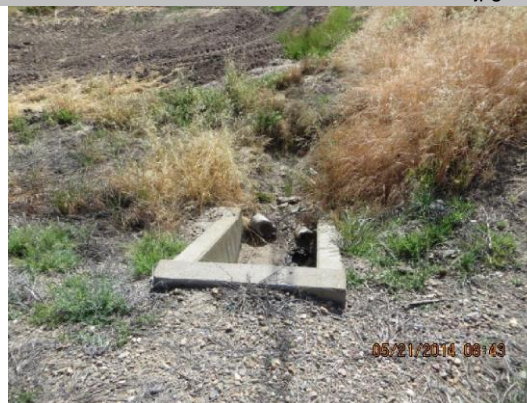
Photo 1 of 3 : UCIP_FA_2017_38140_69413.jpg

LM Start	13.23	Rating **	A/W	Issue No.	1185	
LM End	13.23	Issue Type +	Ma	Location *		
Category	Supplemental			GPS Latitude/Longitude		
				Start		End
Item	DWR UCIP LMA Responsibility			38.101804 °		38.101804 °
				-121.177156 °		-121.177156 °
DWR ID						
Comment Code						
Inspector Comment						
FS_ID:38140 DS_ID:23770 EP_NO: N/A Repair Type: No Action Needed Crossing Status: Found UCIP Comments: FIELD_STRUCT_DESC: 24-inch corrugated metal drainage pipe through the levee, 6 feet below the crown. Concrete U-shaped headwall on both ends. Flap gate on the waterside (WS) end. Cobble grouted spillway. Cobble grouted intake on the landside (LS). [Additional Reference(s): DWR Levee Log, 1990. USACE San Joaquin O&M Manual 612.2, 1967, (HLM 13.60)]. FS Date: 5/21/2014

Headwall on LS toe.

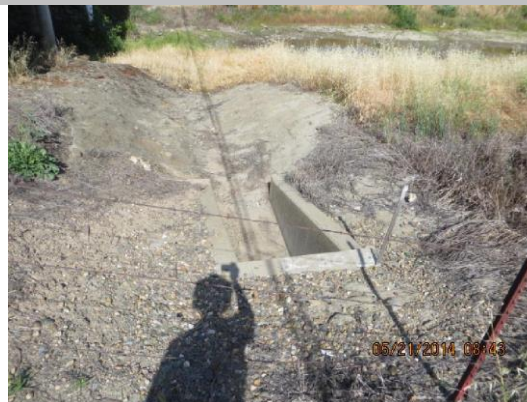
Photo 2 of 3 : UCIP_FA_2017_38140_69412.jpg

Headwall, flapgate, and grouted spillway on WS slope.

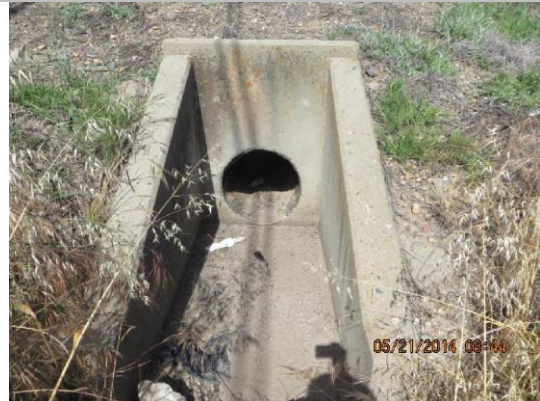
Photo 3 of 3 : UCIP_FA_2017_38140_69411.jpg

LM Start	13.23	Rating **	A/W	Issue No.	1185 (cont)	
LM End	13.23	Issue Type +	Ma	Location *		
Category	Supplemental			GPS Latitude/Longitude		
				Start	End	
Item	DWR UCIP LMA Responsibility			38.101804 °	38.101804 °	
				-121.177156 °	-121.177156 °	
DWR ID						
Comment Code						
Inspector Comment						
FS_ID:38140 DS_ID:23770 EP_NO: N/A Repair Type: No Action Needed Crossing Status: Found UCIP Comments: FIELD_STRUCT_DESC: 24-inch corrugated metal drainage pipe through the levee, 6 feet below the crown. Concrete U-shaped headwall on both ends. Flap gate on the waterside (WS) end. Cobble grouted spillway. Cobble grouted intake on the landside (LS). [Additional Reference(s): DWR Levee Log, 1990. USACE San Joaquin O&M Manual 612.2, 1967, (HLM 13.60)]. FS Date: 5/21/2014

Headwall on LS toe.

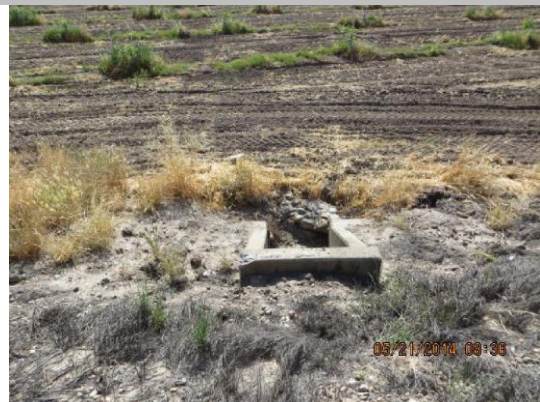
Photo 1 of 3 : UCIP_FA_2017_38139_69408.jpg

LM Start	13.44	Rating **	A/W	Issue No.	1186
LM End	13.44	Issue Type +	Ma	Location *	
Category	Supplemental			GPS Latitude/Longitude	
				Start	End
Item	DWR UCIP LMA Responsibility			38.104814 °	38.104814 °
				-121.176570 °	-121.176570 °
DWR ID					
Comment Code					
Inspector Comment					
FS_ID:38139 DS_ID:23771 EP_NO: N/A Repair Type: No Action Needed Crossing Status: Found UCIP Comments: FIELD_STRUCT_DESC: 24-inch corrugated metal drainage pipe through the levee, 6 feet below the crown. Concrete U-shaped headwall on both ends. Flap gate on the waterside (WS) end. Cobble grouted spillway. Cobble grouted intake on the landside (LS). [Additional Reference(s): DWR Levee Log, 1990. USACE San Joaquin O&M Manual 612.2, 1967, (HLM 13.81)]. FS Date: 5/21/2014

Headwall on LS toe.

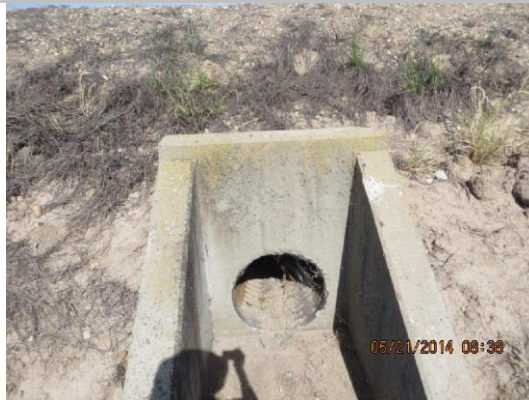
Photo 3 of 3 : UCIP_FA_2017_38139_69406.jpg

Headwall on LS toe.

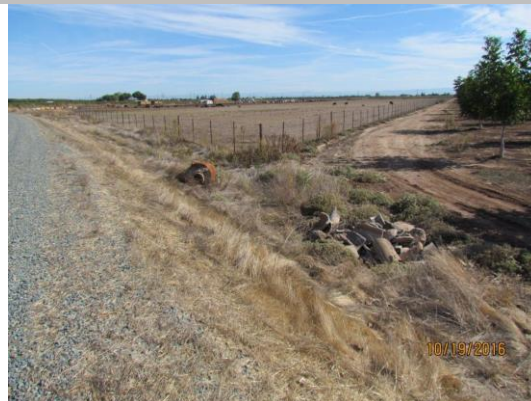
Photo 1 of 1 : FA_2017_NA0017_152_82_20170921_00020.jpg

LM Start	13.72	Rating **	M	Issue No.	82
LM End	13.72	Issue Type +	Ma	Location *	LS
Category	Earthen Levee			GPS Latitude/Longitude	
				Start	End
Item	Encroachments			38.107803 °	38.107803 °
				-121.173179 °	-121.173179 °
DWR ID	DWR_NA0017_08_f_2015_82				
Comment Code					
DE : Debris					
Inspector Comment

View of debris on the landside toe of the levee. Fall 2016

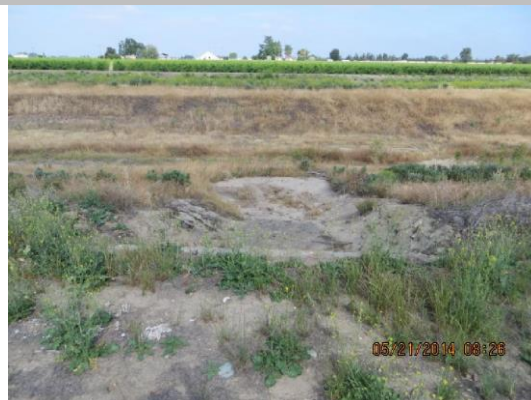
Photo 1 of 3 : UCIP_FA_2017_38137_69401.jpg

LM Start	13.78	Rating **	A/W	Issue No.	1187	
LM End	13.78	Issue Type +	Ma	Location *		
Category	Supplemental			GPS Latitude/Longitude		
				Start	End	
Item	DWR UCIP LMA Responsibility			38.108581 °	38.108581 °	
				-121.172653 °	-121.172653 °	
DWR ID						
Comment Code						
Inspector Comment						
FS_ID:38137 DS_ID:23773 EP_NO: N/A Repair Type: No Action Needed Crossing Status: Found UCIP Comments: FIELD_STRUCT_DESC: 1 of 2: 36-inch corrugated metal drainage pipe through the levee, 4 feet below the crown. Concrete U-shaped headwall on both ends. Flap gate on the waterside (WS) end. Cobble grouted spillway. Cobble grouted intake on the landside (LS). [Additional Reference(s): DWR Levee Log, 1990. USACE San Joaquin O&M Manual 612.2, 1967, (HLM 14.16)]. FS Date: 5/21/2014

Headwall, flapgate, and grouted spillway on WS slope.

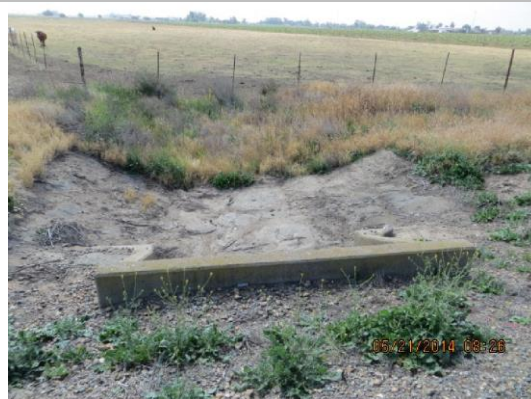
Photo 2 of 3 : UCIP_FA_2017_38137_69400.jpg

Headwall on LS toe.

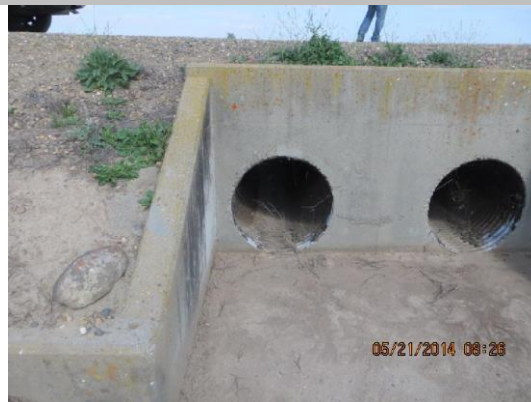
Photo 3 of 3 : UCIP_FA_2017_38137_69399.jpg

Headwall on LS toe.

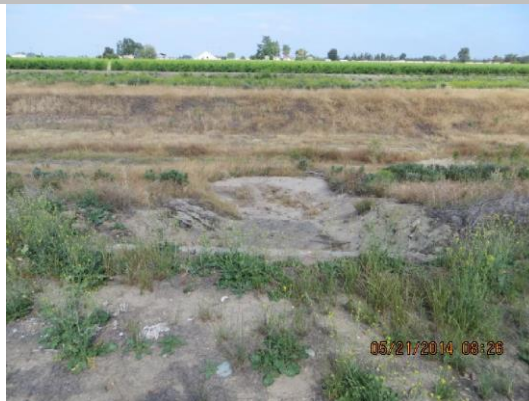
Photo 1 of 3 : UCIP_FA_2017_38136_69396.jpg

LM Start	13.78	Rating **	A/W	Issue No.	1188	
LM End	13.78	Issue Type +	Ma	Location *		
Category	Supplemental			GPS Latitude/Longitude		
				Start	End	
Item	DWR UCIP LMA Responsibility			38.108594 °	38.108594 °	
				-121.172640 °	-121.172640 °	
DWR ID						
Comment Code						
Inspector Comment						
FS_ID:38136 DS_ID:23815 EP_NO: N/A Repair Type: No Action Needed Crossing Status: Found UCIP Comments: FIELD_STRUCT_DESC: 2 of 2: 36-inch corrugated metal drainage pipe through the levee, 4 feet below the crown. Concrete U-shaped headwall on both ends. Flap gate on the waterside (WS) end. Cobble grouted spillway. Cobble grouted intake on the landside (LS). [Additional Reference(s): DWR Levee Log, 1990. USACE San Joaquin O&M Manual 612.2, 1967, (HLM 14.16)]. FS Date: 5/21/2014

Headwall and flapgate on WS slope.

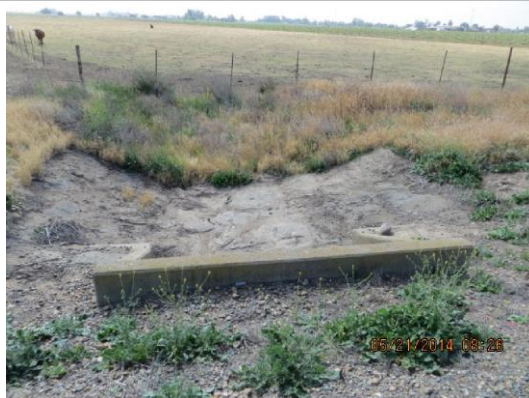
Photo 2 of 3 : UCIP_FA_2017_38136_69395.jpg

LM Start	13.78	Rating **	A/W	Issue No.	1188 (cont)
LM End	13.78	Issue Type +	Ma	Location *

Headwall on LS toe.

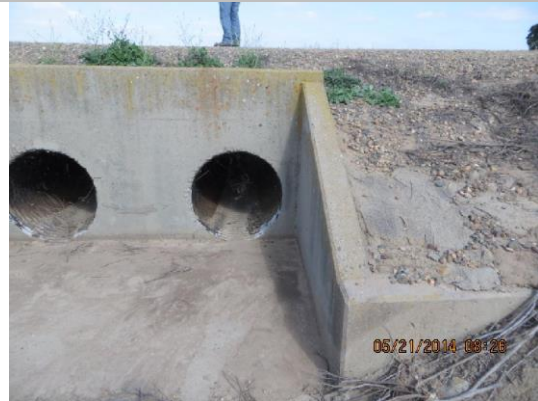
Photo 3 of 3 : UCIP_FA_2017_38136_69394.jpg

LM Start	13.78	Rating **	A/W	Issue No.	1188 (cont)
LM End	13.78	Issue Type +	Ma	Location *	
Category	Supplemental			GPS Latitude/Longitude	
				Start	End
Item	DWR UCIP LMA Responsibility			38.108594 °	38.108594 °
				-121.172640 °	-121.172640 °
DWR ID					
Comment Code					
Inspector Comment					
FS_ID:38136 DS_ID:23815 EP_NO: N/A Repair Type: No Action Needed Crossing Status: Found UCIP Comments: FIELD_STRUCT_DESC: 2 of 2: 36-inch corrugated metal drainage pipe through the levee, 4 feet below the crown. Concrete U-shaped headwall on both ends. Flap gate on the waterside (WS) end. Cobble grouted spillway. Cobble grouted intake on the landside (LS). [Additional Reference(s): DWR Levee Log, 1990. USACE San Joaquin O&M Manual 612.2, 1967, (HLM 14.16)]. FS Date: 5/21/2014

Headwall on LS toe.

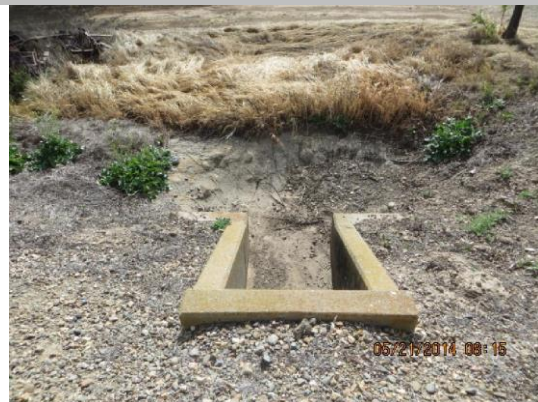
Photo 1 of 3 : UCIP_FA_2017_38134_69389.jpg

LM Start	13.97	Rating **	A/W	Issue No.	1189
LM End	13.97	Issue Type +	Ma	Location *	
Category	Supplemental			GPS Latitude/Longitude	
				Start	End
Item	DWR UCIP LMA Responsibility			38.111250 °	38.111250 °
				-121.172202 °	-121.172202 °
DWR ID					
Comment Code					
Inspector Comment					
FS_ID:38134 DS_ID:23775 EP_NO: N/A Repair Type: No Action Needed Crossing Status: Found UCIP Comments: FIELD_STRUCT_DESC: 24-inch corrugated metal drainage pipe through the levee, 4 feet below the crown. Concrete U-shaped headwall on both ends. Flap gate on the waterside (WS) end. Cobble grouted spillway. Cobble grouted intake on the landside (LS). [Additional Reference(s): DWR Levee Log, 1990. USACE San Joaquin O&M Manual 612.2, 1967, (HLM 14.35)]. FS Date: 5/21/2014

Headwall at LS toe.

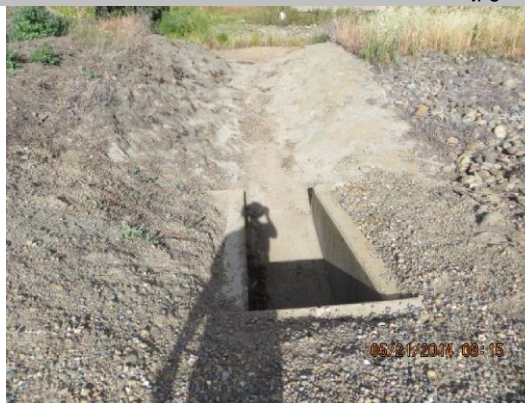
Photo 2 of 3 : UCIP_FA_2017_38134_69388.jpg

Headwall, flapgate, and grouted spillway on WS slope.

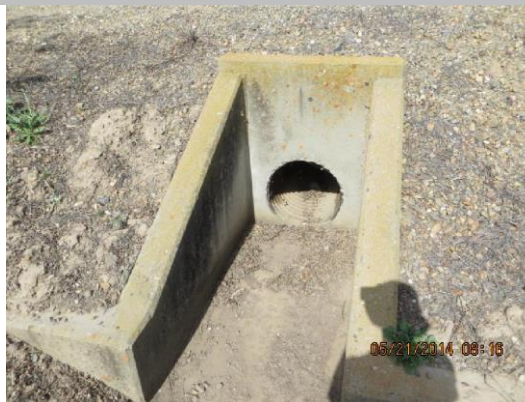
Photo 3 of 3 : UCIP_FA_2017_38134_69387.jpg

Headwall at LS toe.

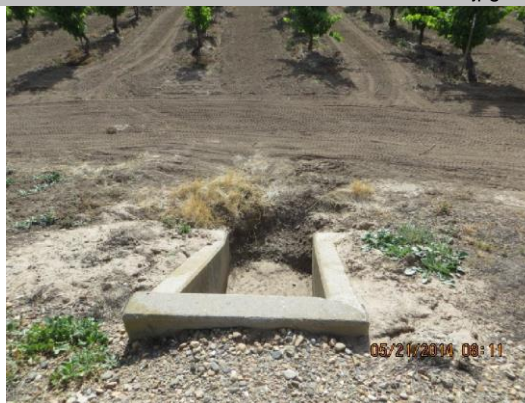
Photo 1 of 3 : UCIP_FA_2017_38133_69384.jpg

LM Start	14.08	Rating **	M	Issue No.	1190
LM End	14.08	Issue Type +	Ma	Location *	
Category	Supplemental			GPS Latitude/Longitude	
				Start	End
Item	DWR UCIP LMA Responsibility			38.112950 °	38.112950 °
				-121.171992 °	-121.171992 °
DWR ID					
Comment Code					
Inspector Comment					
FS_ID:38133 DS_ID:23776 EP_NO: N/A Repair Type: Non-Urgent Crossing Status: Found UCIP Comments: Some silt buildup inside pipe. FIELD_STRUCT_DESC: 24-inch corrugated metal drainage pipe through the levee, 4 feet below the crown. Concrete U-shaped headwall on both ends. Flap gate on the waterside (WS) end. Cobble grouted spillway. Cobble grouted intake on the landside (LS). [Additional Reference(s): DWR Levee Log, 1990. USACE San Joaquin O&M Manual 612.2, 1967, (HLM 14.46)]. FS Date: 5/21/2014

Headwall on LS toe.

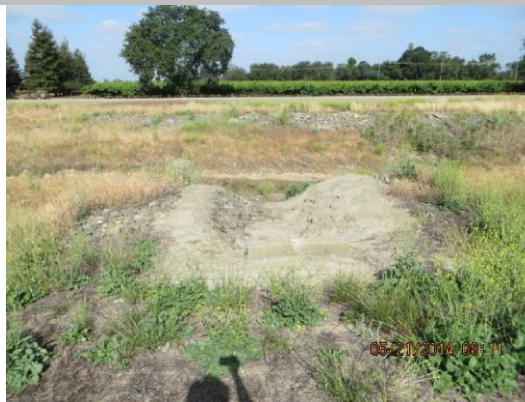
Photo 2 of 3 : UCIP_FA_2017_38133_69383.jpg

Headwall, flapgate, and grouted spillway on WS slope.

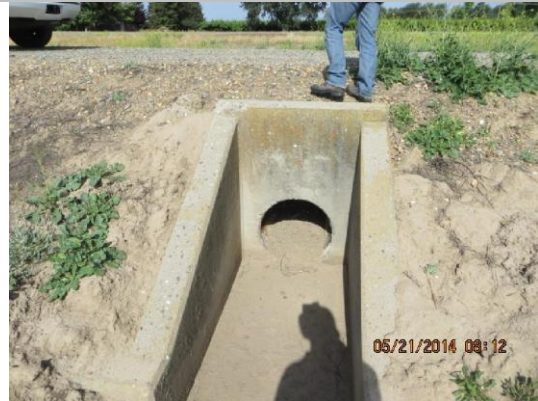
Photo 3 of 3 : UCIP_FA_2017_38133_69382.jpg

LM Start	14.08	Rating **	M	Issue No.	1190 (cont)	
LM End	14.08	Issue Type +	Ma	Location *		
Category	Supplemental			GPS Latitude/Longitude		
				Start	End	
Item	DWR UCIP LMA Responsibility			38.112950 °	38.112950 °	
				-121.171992 °	-121.171992 °	
DWR ID						
Comment Code						
Inspector Comment						
FS_ID:38133 DS_ID:23776 EP_NO: N/A Repair Type: Non-Urgent Crossing Status: Found UCIP Comments: Some silt buildup inside pipe. FIELD_STRUCT_DESC: 24-inch corrugated metal drainage pipe through the levee, 4 feet below the crown. Concrete U-shaped headwall on both ends. Flap gate on the waterside (WS) end. Cobble grouted spillway. Cobble grouted intake on the landside (LS). [Additional Reference(s): DWR Levee Log, 1990. USACE San Joaquin O&M Manual 612.2, 1967, (HLM 14.46)]. FS Date: 5/21/2014

Headwall on LS toe.

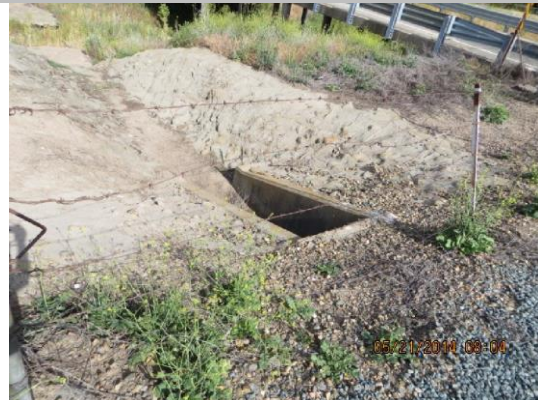
Photo 1 of 3 : UCIP_FA_2017_38130_69375.jpg

LM Start	14.31	Rating **	M	Issue No.	1191
LM End	14.31	Issue Type +	Ma	Location *	
Category	Supplemental			GPS Latitude/Longitude	
				Start	End
Item	DWR UCIP LMA Responsibility			38.116164 °	38.116164 °
				-121.171657 °	-121.171657 °
DWR ID					
Comment Code					
Inspector Comment					
FS_ID:38130 DS_ID:23778 EP_NO: N/A Repair Type: Non-Urgent Crossing Status: Found UCIP Comments: Some silt buildup inside pipe. FIELD_STRUCT_DESC: 24-inch corrugated metal drainage pipe on both ends. Flap gate on the waterside (WS) end. Cobble grouted spillway. Cobble grouted intake on the landside (LS). [Additional Reference(s): DWR Levee Log, 1990. USACE San Joaquin O&M Manual 612.2, 1967, (HLM 14.69)]. FS Date: 5/21/2014

Headwall, flapgate, and grouted spillway on WS slope.

FS_ID:38130
DS_ID:23778
EP_NO: N/A
Repair Type: Non-Urgent
Crossing Status: Found
UCIP Comments: Some silt buildup inside pipe.
FIELD_STRUCT_DESC: 24-inch corrugated metal drainage pipe through the levee, 4 feet below the crown. Concrete U-shaped headwall on both ends. Flap gate on the waterside (WS) end. Cobble grouted spillway. Cobble grouted intake on the landside (LS). [Additional Reference(s): DWR Levee Log, 1990. USACE San Joaquin O&M Manual 612.2, 1967, (HLM 14.69)].
FS Date: 5/21/2014

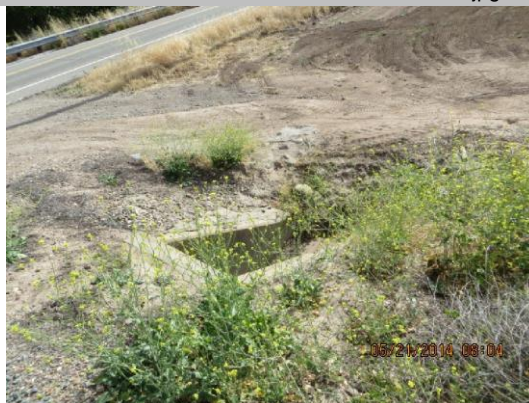
Photo 2 of 3 : UCIP_FA_2017_38130_69374.jpg

Headwall on LS toe.

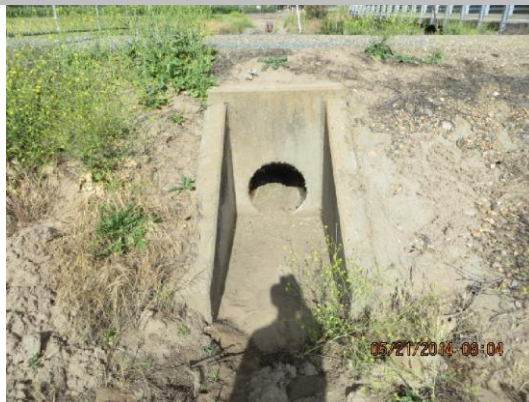
Photo 3 of 3 : UCIP_FA_2017_38130_69373.jpg

Headwall on LS toe.

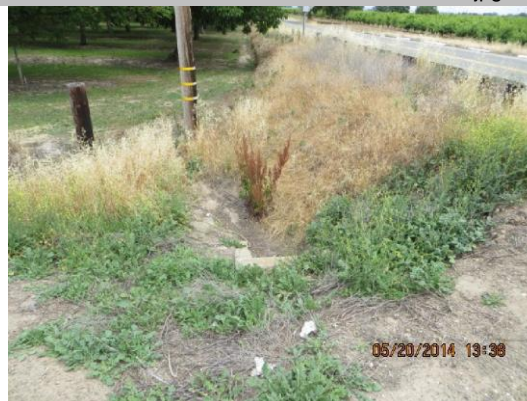
Photo 1 of 3 : UCIP_FA_2017_38129_69370.jpg

LM Start	14.32	Rating **	A/W	Issue No.	1193	
LM End	14.32	Issue Type +	Ma	Location *		
Category	Supplemental			GPS Latitude/Longitude		
				Start		End
Item	DWR UCIP LMA Responsibility			38.116420 °		38.116420 °
				-121.171643 °		-121.171643 °
DWR ID						
Comment Code						
Inspector Comment						
FS_ID:38129						
DS_ID:23779						
EP_NO: N/A						
Repair Type: No Action Needed						
Crossing Status: Found						
UCIP Comments:						
FIELD_STRUCT_DESC: 24-inch corrugated metal drainage pipe through the levee, 6.5 feet below the crown. Concrete U-shaped headwall on both ends. Flap gate on the waterside (WS) end. Cobble grouted spillway. Cobble grouted intake on the landside (LS). [Additional Reference(s): DWR Levee Log, 1990. USACE San Joaquin O&M Manual 612.2, 1967, (HLM 14.70)].						
FS Date: 5/20/2014

Headwall on LS toe.

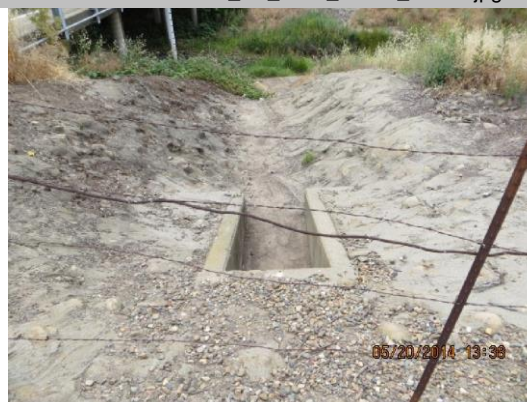
Photo 2 of 3 : UCIP_FA_2017_38129_69369.jpg

Headwall and flapgate on WS toe.
