**Flood Control Project Maintenance
Levee Inspections**

Maintenance Issue Types Only, Levee Inspection Report By Mile - Fall 2017

San Joaquin County Flood Control and Water Conservation District

Waterway	Bank	Unit Miles	Inspection Start/End	Inspector
Unit No. 01 Littlejohn Creek	Left	2.59	10/17/2017 10/17/2017	Pavel Kazi

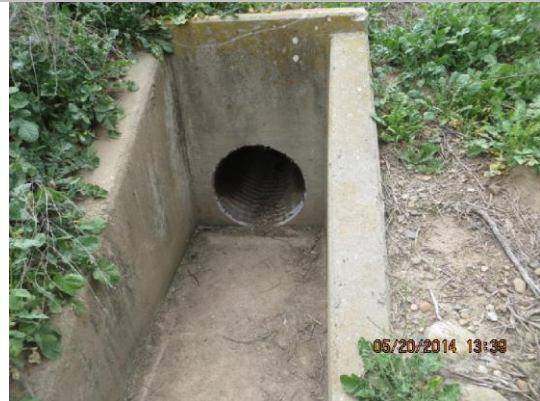
Photo 3 of 3 : UCIP_FA_2017_38129_69368.jpg

LM Start	14.32	Rating **	A/W	Issue No.	1193 (cont)	
LM End	14.32	Issue Type +	Ma	Location *		
Category	Supplemental			GPS Latitude/Longitude		
				Start	End	
Item	DWR UCIP LMA Responsibility			38.116420 °	38.116420 °	
				-121.171643 °	-121.171643 °	
DWR ID						
Comment Code						
Inspector Comment						
FS_ID:38129						
DS_ID:23779						
EP_NO: N/A						
Repair Type: No Action Needed						
Crossing Status: Found						
UCIP Comments:						
FIELD_STRUCT_DESC: 24-inch corrugated metal drainage pipe through the levee, 6.5 feet below the crown. Concrete U-shaped headwall on both ends. Flap gate on the waterside (WS) end. Cobble grouted spillway. Cobble grouted intake on the landside (LS). [Additional Reference(s): DWR Levee Log, 1990. USACE San Joaquin O&M Manual 612.2, 1967, (HLM 14.70)].						
FS Date: 5/20/2014

Headwall at LS toe.

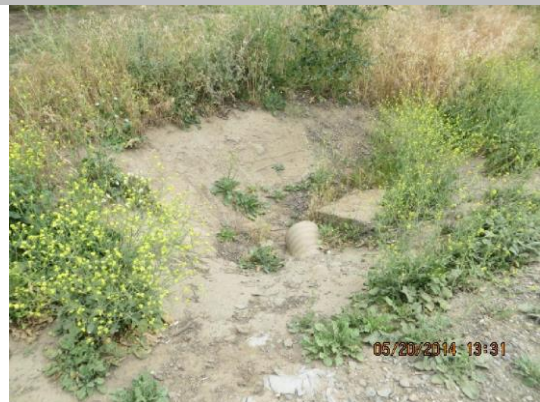
Photo 1 of 3 : UCIP_FA_2017_38127_69362.jpg

LM Start	14.70	Rating **	A/W	Issue No.	1194
LM End	14.70	Issue Type +	Ma	Location *	
Category	Supplemental			GPS Latitude/Longitude	
				Start	End
Item	DWR UCIP LMA Responsibility			38.121425 °	38.121425 °
				-121.169179 °	-121.169179 °
DWR ID					
Comment Code					
Inspector Comment					
FS_ID:38127					
DS_ID:23780					
EP_NO: N/A					
Repair Type: No Action Needed					
Crossing Status: Found					
UCIP Comments:					
FIELD_STRUCT_DESC: 12-inch corrugated metal drainage pipe through the levee, 3 feet below the crown. Flap gate on the waterside (WS) end. Cobble grouted spillway. Cobble grouted intake on the landside (LS). [Additional Reference(s): DWR Levee Log, 1990. USACE San Joaquin O&M Manual 612.2, 1967, (HLM 15.08)].					
FS Date: 5/20/2014

Pipe at LS toe.

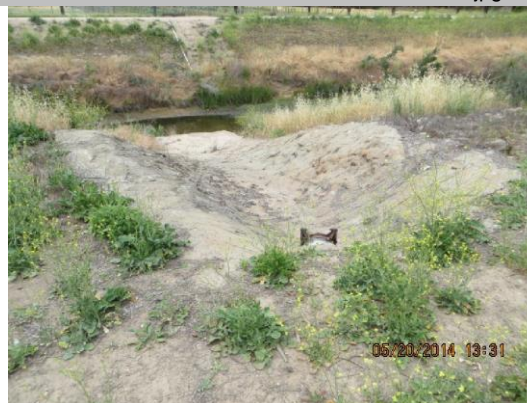
Photo 2 of 3 : UCIP_FA_2017_38127_69361.jpg

LM Start	14.70	Rating **	A/W	Issue No.	1194 (cont)	
LM End	14.70	Issue Type +	Ma	Location *		
Category	Supplemental			GPS Latitude/Longitude		
				Start	End	
Item	DWR UCIP LMA Responsibility			38.121425 °	38.121425 °	
				-121.169179 °	-121.169179 °	
DWR ID						
Comment Code						
Inspector Comment						
FS_ID:38127						
DS_ID:23780						
EP_NO: N/A						
Repair Type: No Action Needed						
Crossing Status: Found						
UCIP Comments:						
FIELD_STRUCT_DESC: 12-inch corrugated metal drainage pipe						
through the levee, 3 feet below the crown. Flap gate on the waterside						
(WS) end. Cobble grouted spillway. Cobble grouted intake on the						
landside (LS). [Additional Reference(s): DWR Levee Log, 1990. USACE						
San Joaquin O&M Manual 612.2, 1967, (HLM 15.08)].						
FS Date: 5/20/2014

Pipe, flapgate, and grouted spillway on WS slope.

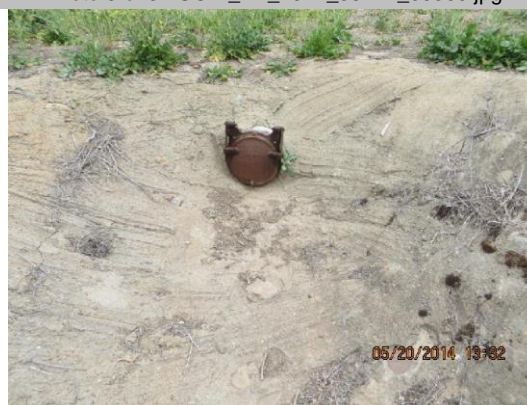
Photo 3 of 3 : UCIP_FA_2017_38127_69360.jpg

Pipe, flapgate, and grouted spillway on WS slope.

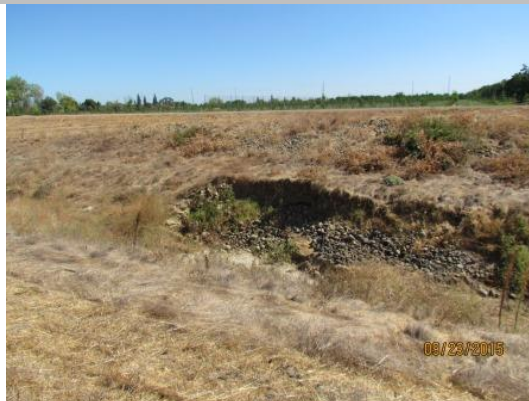
Photo 1 of 1 : FA_2017_NA0017_152_57_20170921_00013.jpg

LM Start	14.75	Rating **	A/W	Issue No.	57
LM End	14.75	Issue Type +	Ma	Location *	WS
Category	Earthen Levee			GPS Latitude/Longitude	
				Start	End
Item	Erosion / Bank Caving			38.122152 °	38.122152 °
				-121.169461 °	-121.169461 °
DWR ID	DWR_NA0017_08_f_2015_57				
Comment Code					
E2 : Schedule repair of erosion site prior to the next inspection.					
Inspector Comment					
Waterside toe erosion.

Erosion was found on the waterside toe of the levee. The picture was taken from the right bank of the levee.

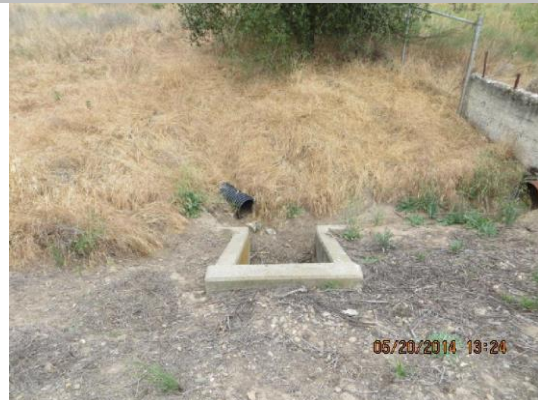
Photo 1 of 3 : UCIP_FA_2017_38126_69357.jpg

LM Start	14.85	Rating **	A/W	Issue No.	1195
LM End	14.85	Issue Type +	Ma	Location *	
Category	Supplemental			GPS Latitude/Longitude	
				Start	End
Item	DWR UCIP LMA Responsibility			38.123628 °	38.123628 °
				-121.169175 °	-121.169175 °
DWR ID					
Comment Code					
Inspector Comment					
FS_ID:38126 DS_ID:23781 EP_NO: N/A Repair Type: No Action Needed Crossing Status: Found UCIP Comments: FIELD_STRUCT_DESC: 24-inch corrugated metal drainage pipe through the levee, 6 feet below the crown. Concrete U-shaped headwall on both ends. Flap gate on the waterside (WS) end. Cobble grouted spillway. Cobble grouted inlet on the landside (LS). [Additional Reference(s): DWR Levee Log, 1990. USACE San Joaquin O&M Manual 612.2, 1967, (HLM 15.24)]. FS Date: 5/20/2014

Headwall at LS toe.

FS_ID:38126
DS_ID:23781
EP_NO: N/A
Repair Type: No Action Needed
Crossing Status: Found
UCIP Comments:
FIELD_STRUCT_DESC: 24-inch corrugated metal drainage pipe through the levee, 6 feet below the crown. Concrete U-shaped headwall on both ends. Flap gate on the waterside (WS) end. Cobble grouted spillway. Cobble grouted inlet on the landside (LS). [Additional Reference(s): DWR Levee Log, 1990. USACE San Joaquin O&M Manual 612.2, 1967, (HLM 15.24)].
FS Date: 5/20/2014

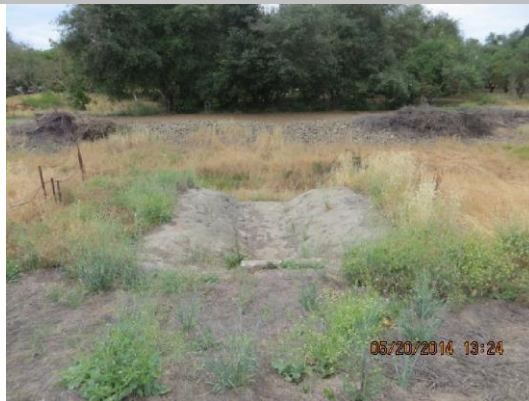
Photo 2 of 3 : UCIP_FA_2017_38126_69356.jpg

Headwall, flapgate, and grouted spillway on WS toe.

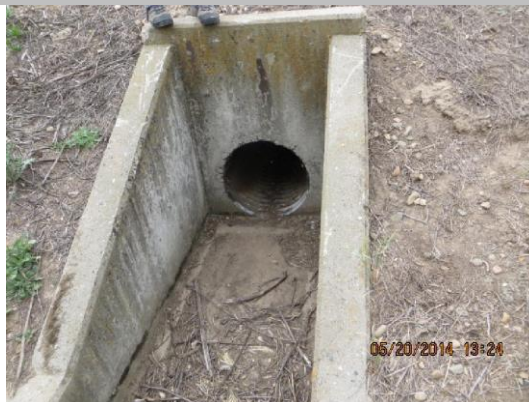
Photo 3 of 3 : UCIP_FA_2017_38126_69355.jpg

Headwall at LS toe.

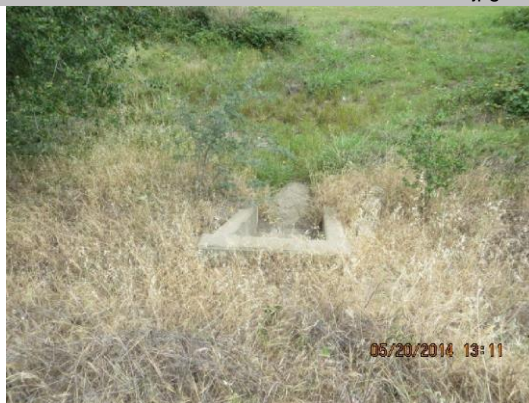
Photo 1 of 3 : UCIP_FA_2017_38125_69352.jpg

LM Start	15.05	Rating **	A/W	Issue No.	1197	
LM End	15.05	Issue Type +	Ma	Location *		
Category	Supplemental			GPS Latitude/Longitude		
				Start		End
Item	DWR UCIP LMA Responsibility			38.125741 °	38.125741 °	
				-121.166840 °	-121.166840 °	
DWR ID						
Comment Code						
Inspector Comment						
FS_ID:38125 DS_ID:23782 EP_NO: N/A Repair Type: No Action Needed Crossing Status: Found UCIP Comments: FIELD_STRUCT_DESC: 24-inch corrugated metal drainage pipe through the levee, 6 feet below the crown. Concrete U-shaped headwall on both ends. Flap gate on the waterside (WS) end. Cobble grouted spillway. Cobble grouted intake on the landside (LS). [Additional Reference(s): DWR Levee Log, 1990. USACE San Joaquin O&M Manual 612.2, 1967, (HLM 15.44)]. FS Date: 5/20/2014

Headwall at LS toe.

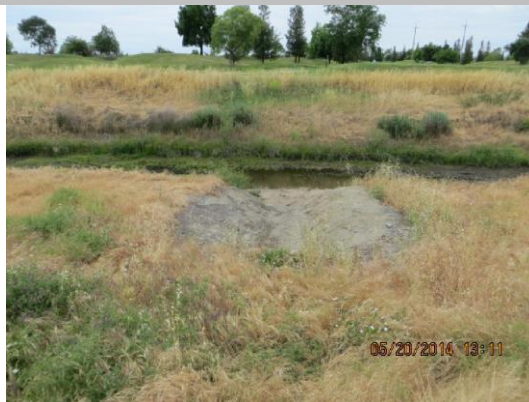
Photo 2 of 3 : UCIP_FA_2017_38125_69351.jpg

Headwall, flapgate, and grouted spillway on WS toe.

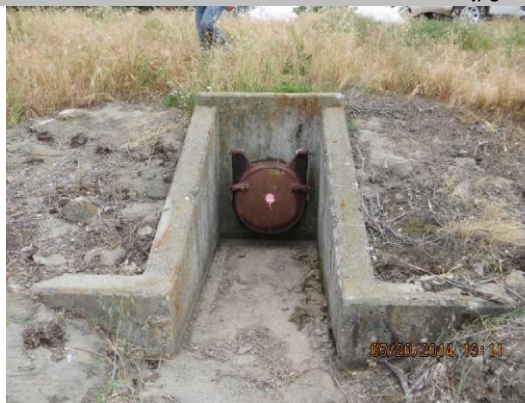
Photo 3 of 3 : UCIP_FA_2017_38125_69350.jpg

LM Start	15.05	Rating **	A/W	Issue No.	1197 (cont)	
LM End	15.05	Issue Type +	Ma	Location *		
Category	Supplemental			GPS Latitude/Longitude		
				Start	End	
Item	DWR UCIP LMA Responsibility			38.125741 °	38.125741 °	
				-121.166840 °	-121.166840 °	
DWR ID						
Comment Code						
Inspector Comment						
FS_ID:38125 DS_ID:23782 EP_NO: N/A Repair Type: No Action Needed Crossing Status: Found UCIP Comments: FIELD_STRUCT_DESC: 24-inch corrugated metal drainage pipe through the levee, 6 feet below the crown. Concrete U-shaped headwall on both ends. Flap gate on the waterside (WS) end. Cobble grouted spillway. Cobble grouted intake on the landside (LS). [Additional Reference(s): DWR Levee Log, 1990. USACE San Joaquin O&M Manual 612.2, 1967, (HLM 15.44)]. FS Date: 5/20/2014

Headwall and flapgate at WS toe.

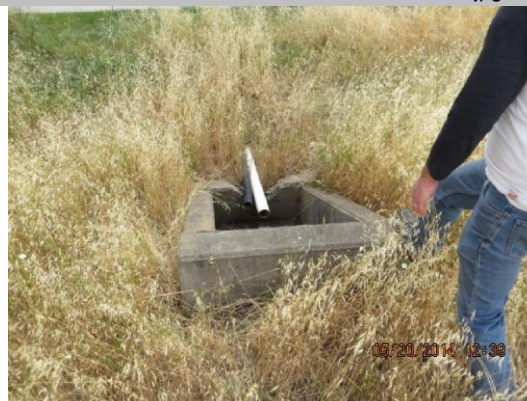
Photo 1 of 3 : UCIP_FA_2017_38122_69342.jpg

LM Start	15.62	Rating **	A/W	Issue No.	1205
LM End	15.62	Issue Type +	Ma	Location *	
Category	Supplemental			GPS Latitude/Longitude	
				Start	End
Item	DWR UCIP LMA Responsibility			38.129880 °	38.129880 °
				-121.158017 °	-121.158017 °
DWR ID					
Comment Code					
Inspector Comment					
FS_ID:38122 DS_ID:23784 EP_NO: N/A Repair Type: No Action Needed Crossing Status: Found UCIP Comments: FIELD_STRUCT_DESC: 24-inch corrugated metal drainage pipe through the levee, 3 feet below the crown. Concrete U-shaped headwall on both ends. Flap gate on the waterside (WS) end. Cobble grouted spillway. Cobble grouted intake on the landside (LS). [Additional Reference(s): DWR Levee Log, 1990. USACE San Joaquin O&M Manual 612.2, 1967, (HLM 16.02)]. FS Date: 5/20/2014

Headwall on LS toe.

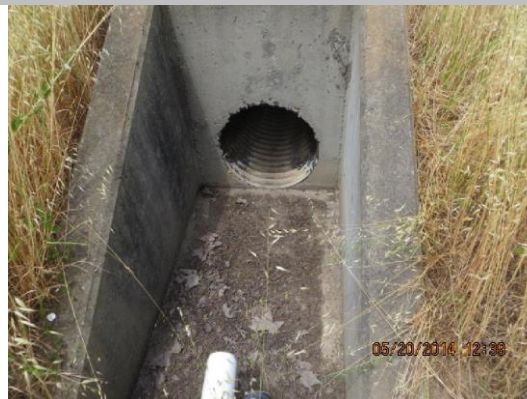
Photo 2 of 3 : UCIP_FA_2017_38122_69341.jpg

Headwall on LS toe.

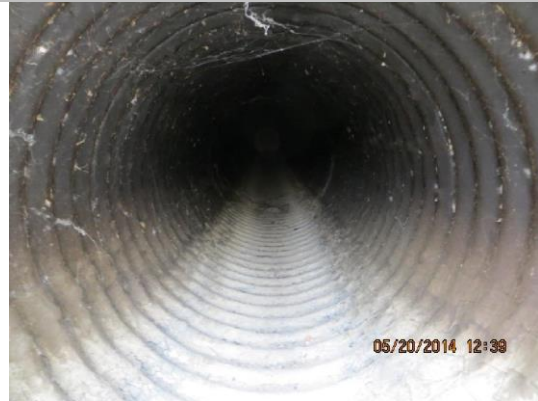
Photo 3 of 3 : UCIP_FA_2017_38122_69340.jpg

Inside pipe at LS toe.

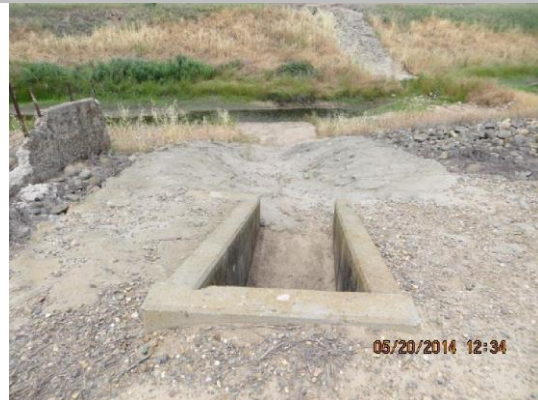
Photo 1 of 3 : UCIP_FA_2017_38121_69337.jpg

Headwall, flapgate, and grouted spillway on WS slope.

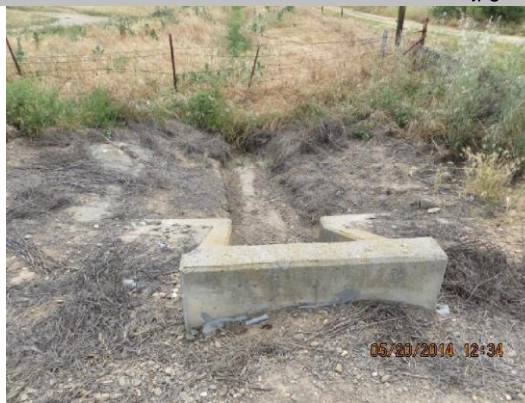
Photo 2 of 3 : UCIP_FA_2017_38121_69336.jpg

Headwall on LS toe.

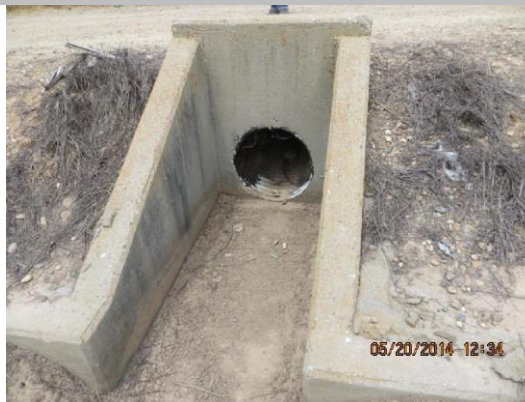
Photo 3 of 3 : UCIP_FA_2017_38121_69335.jpg

Headwall on LS toe.

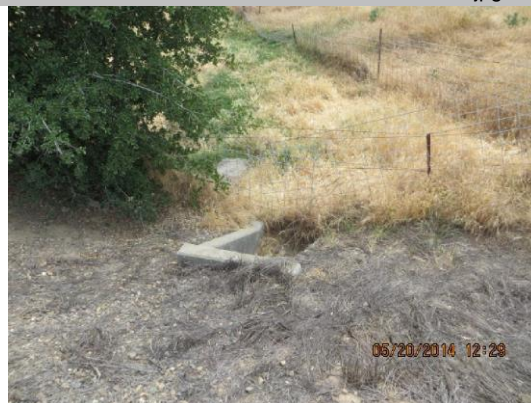
Photo 1 of 3 : UCIP_FA_2017_38120_69333.jpg

Headwall at LS toe.

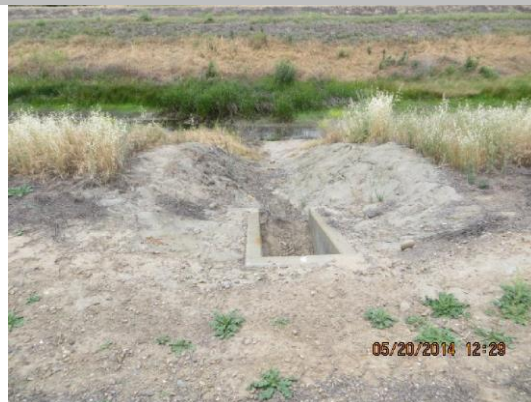
Photo 2 of 3 : UCIP_FA_2017_38120_69332.jpg

Headwall and flapgate at WS toe.

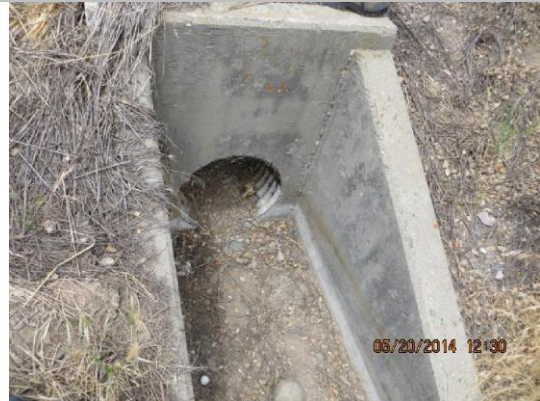
Photo 3 of 3 : UCIP_FA_2017_38120_69331.jpg

Headwall at LS toe.

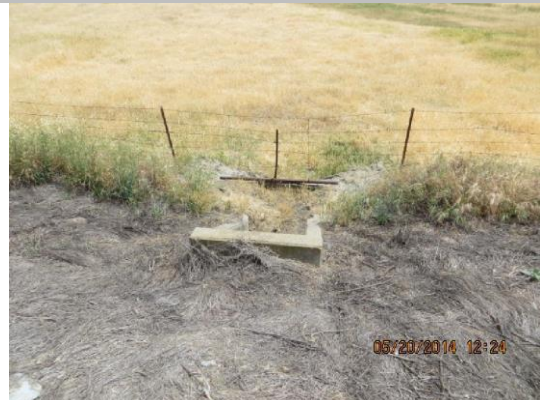
Photo 1 of 3 : UCIP_FA_2017_38119_69328.jpg

Concrete headwall on LS toe.

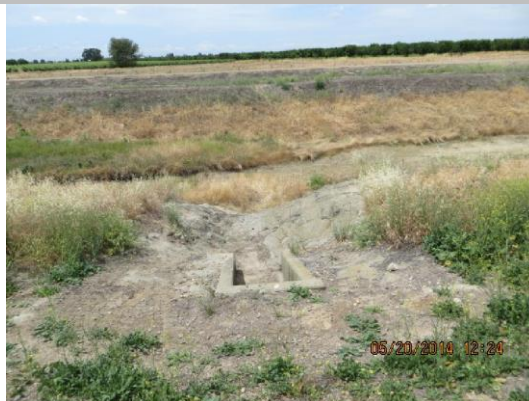
Photo 2 of 3 : UCIP_FA_2017_38119_69327.jpg

Flapgate and headwall on WS toe.

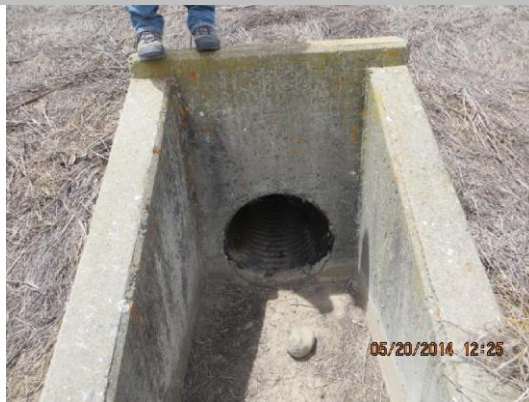
Photo 3 of 3 : UCIP_FA_2017_38119_69326.jpg

Concrete headwall on LS toe.

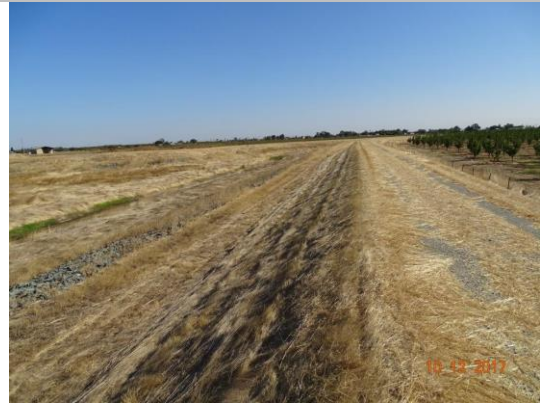
Photo 1 of 1 : FA_2017_NA0017_153_15_20171016_00070.jpg

LM Start	0.01	Rating **	A	Issue No.	15
LM End	0.01	Issue Type +	Ma	Location *	WS
Category	Earthen Levee			GPS Latitude/Longitude	
				Start	End
Item	Vegetation			38.093157 °	38.093157 °
				-121.176309 °	-121.176309 °
DWR ID	DWR_NA0017_09_f_2017_15				
Comment Code					
V1 : Control annual grass and weeds on the levee slopes and easements.					
Inspector Comment					
Acceptable vegetation.

View of the waterside slope of the levee. Fall 2017

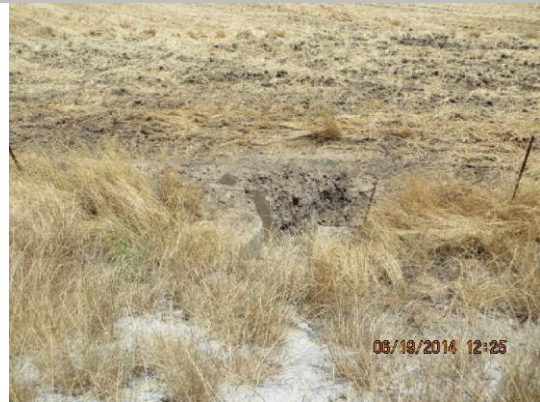
Photo 1 of 3 : UCIP_FA_2017_38975_71120.jpg

Pipe and headwall on LS toe.

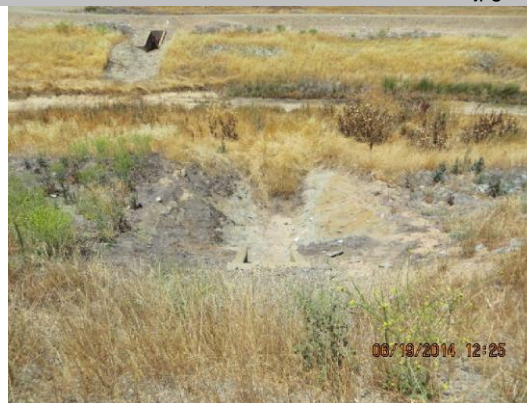
Photo 2 of 3 : UCIP_FA_2017_38975_71119.jpg

Pipe, flapgate, and grouted spillway on WS slope.

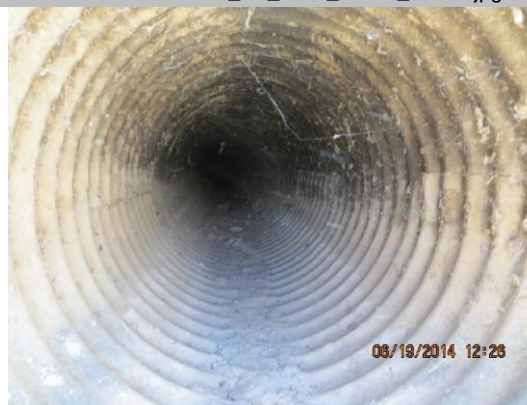
Photo 3 of 3 : UCIP_FA_2017_38975_71123.jpg

Inside pipe at LS toe.

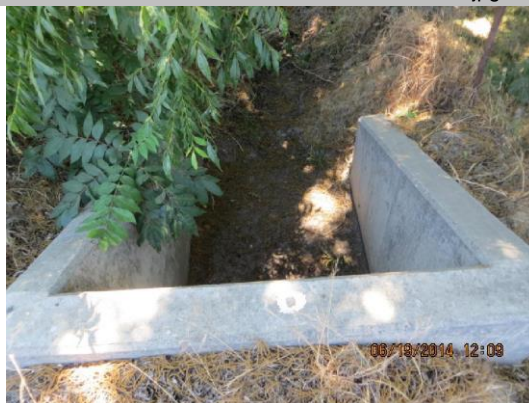
Photo 1 of 3 : UCIP_FA_2017_38973_71110.jpg

Pipe and headwall on LS toe.

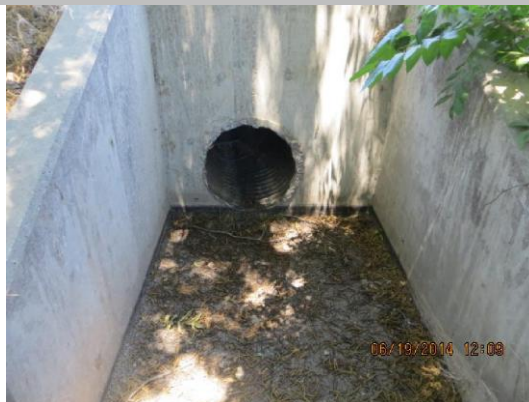
Photo 2 of 3 : UCIP_FA_2017_38973_71109.jpg

Pipe and headwall on LS toe.

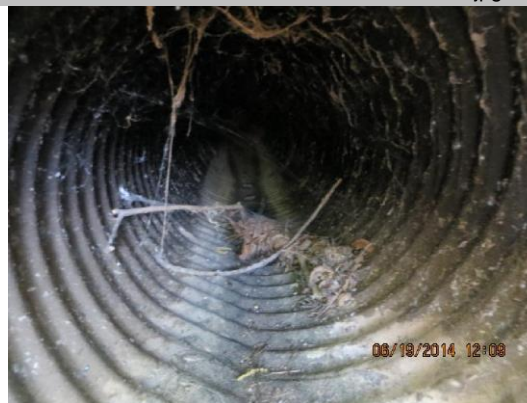
Photo 3 of 3 : UCIP_FA_2017_38973_71108.jpg

Inside pipe at LS toe.

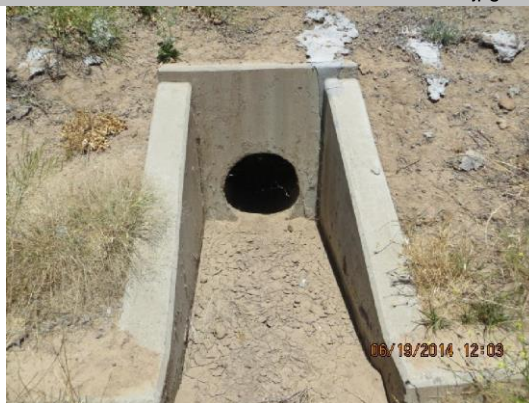
Photo 3 of 3 : UCIP_FA_2017_38972_71103.jpg

Comment Code						
Inspector Comment						
FS_ID:38972 DS_ID:23839 EP_NO: N/A Repair Type: No Action Needed Crossing Status: Found UCIP Comments: Suction hose and appurtances appear to be abandoned. FIELD_STRUCT_DESC: 24-inch corrugated metal drainage pipe through the levee, 8 feet below the crown. Concrete U-shaped headwall on both ends. Flap gate on the waterside (WS) end. Cobble grouted spillway. Cobble grouted intake on the landside (LS). Pump with suction hose sleeved through storm drainage pipe located on the LS, removed during winter months. (Suction hose sleeved through pipe under Permit No. 11530, 1976 - Constantine M. Coppulos). [Additional Reference(s): DWR Levee Log, 1987. USACE San Joaquin O&M Manual 612.2, 1967, (HLM 0.62) and 612 (addendum), February 1999, (HLM 0.61) (Station 32+46)]. FS Date: 6/19/2014

Pipe and headwall on LS toe.

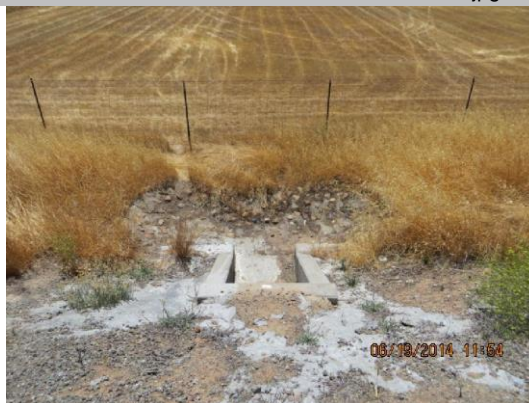
Photo 1 of 3 : UCIP_FA_2017_38971_71100.jpg

Pipe and headwall on LS toe.

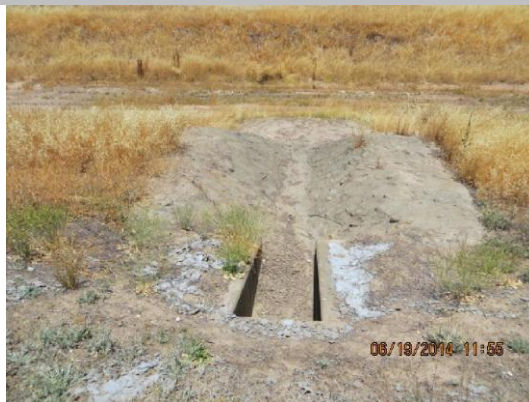
Photo 2 of 3 : UCIP_FA_2017_38971_71099.jpg

Pipe, flapgate, and grouted spillway on WS slope.

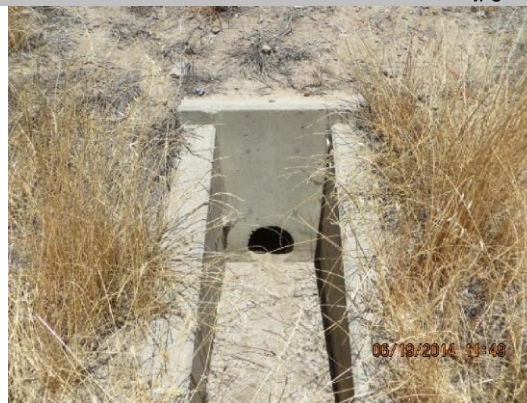
Photo 2 of 3 : UCIP_FA_2017_41812_71094.jpg

Pipe and headwall on LS toe.

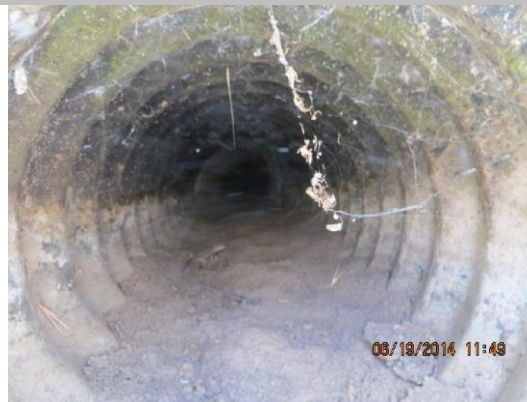
Photo 3 of 3 : UCIP_FA_2017_41812_71093.jpg

Inside pipe at LS toe.

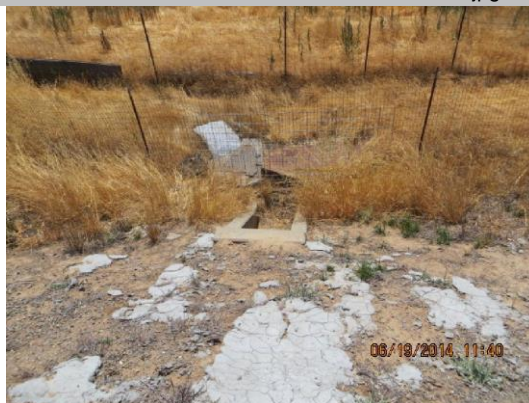
Photo 1 of 3 : UCIP_FA_2017_38969_71090.jpg

Pipe and headwall on LS toe.

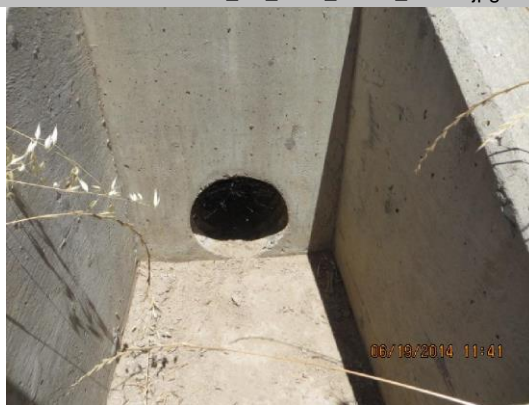
Photo 2 of 3 : UCIP_FA_2017_38969_71089.jpg

Pipe and headwall on LS toe.

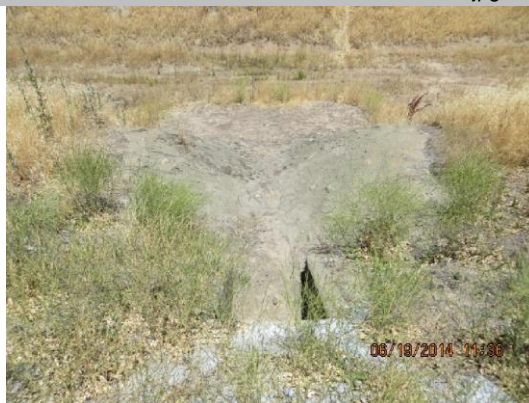
Photo 2 of 3 : UCIP_FA_2017_38968_71084.jpg

LM Start	1.08	Rating **	A/W	Issue No.	22 (cont)	
LM End	1.08	Issue Type +	Ma	Location *		
Category	Supplemental			GPS Latitude/Longitude		
				Start		End
Item	DWR UCIP LMA Responsibility			38.094318	°	38.094318
				-121.157487	°	-121.157487
DWR ID						
Comment Code						
Inspector Comment						
FS_ID:38968 DS_ID:23843 EP_NO: N/A Repair Type: No Action Needed Crossing Status: Found UCIP Comments: FIELD_STRUCT_DESC: 24-inch corrugated metal drainage pipe through the levee, 4.5 feet below the crown. Concrete U-shaped headwall on both ends. Flap gate on the waterside (WS) end. One corrugated metal cutoff wall. Cobble grouted spillway. Cobble grouted intake on the landside (LS). [Additional Reference(s): DWR Levee Log, 1987. USACE San Joaquin O&M Manual 612.2, 1967, (HLM 1.09) and 612 (addendum), February 1999, (HLM 1.09) (Station 57+30)]. FS Date: 6/19/2014

Pipe, flapgate, and grouted spillway on WS toe.

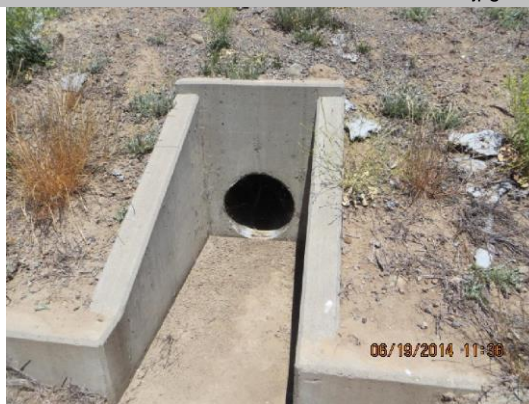
Photo 3 of 3 : UCIP_FA_2017_38968_71083.jpg

Headwall at LS toe.

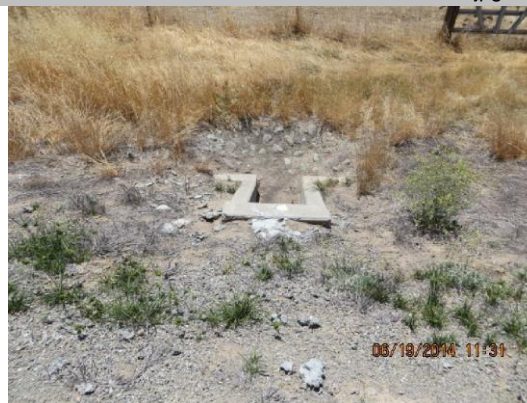
Photo 1 of 3 : UCIP_FA_2017_38967_71079.jpg

LM Start	1.16	Rating **	A/W	Issue No.	23
LM End	1.16	Issue Type +	Ma	Location *	
Category	Supplemental			GPS Latitude/Longitude	
				Start	End
Item	DWR UCIP LMA Responsibility			38.094356 °	38.094356 °
				-121.155924 °	-121.155924 °
DWR ID					
Comment Code					
Inspector Comment					
FS_ID:38967					
DS_ID:23844					
EP_NO: N/A					
Repair Type: No Action Needed					
Crossing Status: Found					
UCIP Comments:					
FIELD_STRUCT_DESC: 12-inch corrugated metal drainage pipe through the levee, 7 feet below the crown. Headwall on the landside (LS) toe. Flap gate on the waterside (WS) end. Cobble grouted spillway. [Additional Reference(s): DWR Levee Log, 1987. USACE San Joaquin O&M Manual 612.2, 1967, (HLM 1.18) and 612 (addendum), February 1999, (HLM 1.17) (Station 61+82)].					
FS Date: 6/19/2014

Pipe and headwall on LS toe.

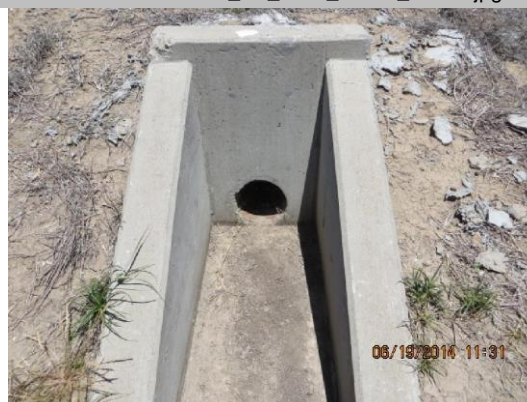
Photo 2 of 3 : UCIP_FA_2017_38967_71078.jpg

Pipe and headwall on LS toe.

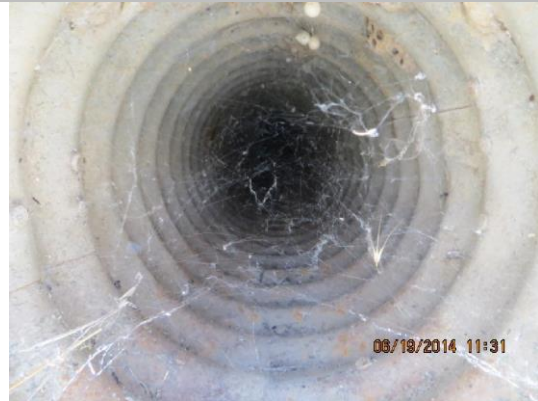
Photo 3 of 3 : UCIP_FA_2017_38967_71082.jpg

Inside pipe at LS toe.

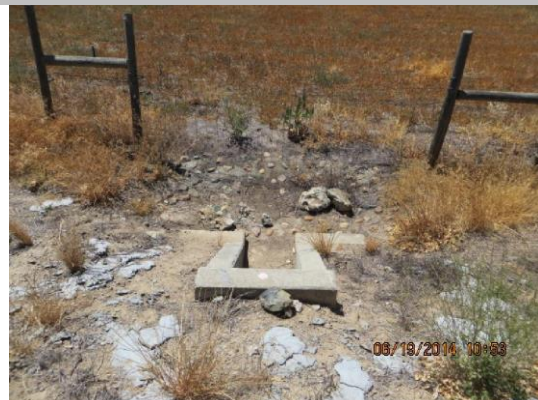
Photo 1 of 3 : UCIP_FA_2017_38997_71074.jpg

LM Start	1.22	Rating **	A/W	Issue No.	24
LM End	1.22	Issue Type +	Ma	Location *	
Category	Supplemental			GPS Latitude/Longitude	
				Start	End
Item	DWR UCIP LMA Responsibility			38.094423 °	38.094423 °
				-121.154902 °	-121.154902 °
DWR ID					
Comment Code					
Inspector Comment					
FS_ID:38997					
DS_ID:23845					
EP_NO: N/A					
Repair Type: No Action Needed					
Crossing Status: Found					
UCIP Comments:					
FIELD_STRUCT_DESC: 12-inch corrugated metal storm drainage pipe through the levee, 6.5 feet below the crown. Flap gate on the waterside (WS) end. Cobble grouted spillway. [Additional Reference(s): DWR Levee Log, 1987. USACE San Joaquin O&M Manual 612.2, 1967, (HLM 1.23) and 612 (addendum), February 1999, (HLM 1.23) (Station 64+78)].					
FS Date: 6/19/2014

Headwall at LS toe.

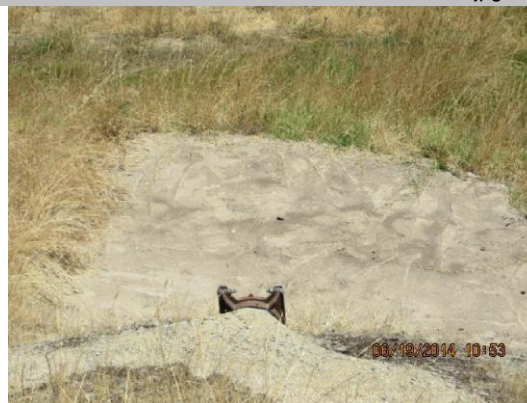
Photo 2 of 3 : UCIP_FA_2017_38997_71073.jpg

Pipe, flapgate, and grouted spillway on WS toe.

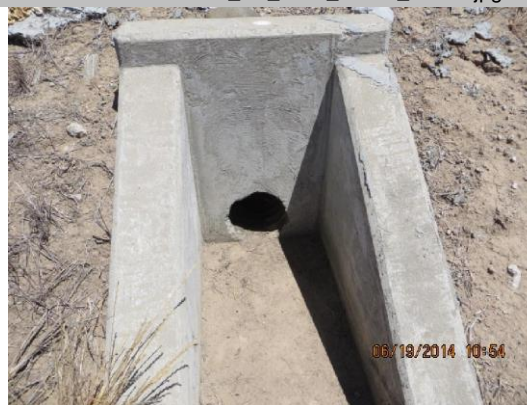
Photo 3 of 3 : UCIP_FA_2017_38997_71077.jpg

Headwall on LS toe.

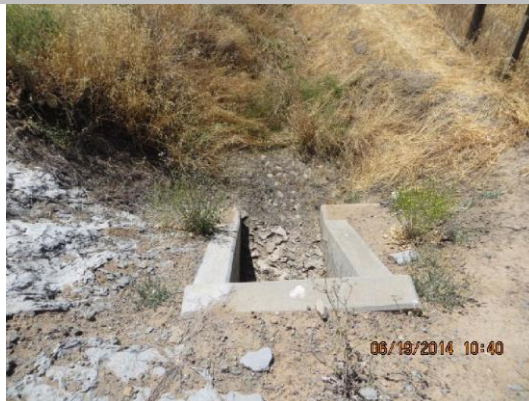
Photo 1 of 3 : UCIP_FA_2017_38977_71064.jpg

FS_ID:38977
DS_ID:23847
EP_NO: N/A
Repair Type: Non-Urgent
Crossing Status: Found
UCIP Comments: Flapgate blocked by soil and possibly concrete on WS slope.
FIELD_STRUCT_DESC: 21-inch corrugated metal drainage pipe through the levee, 5.5 feet below the crown. Flap gate on the waterside (WS) end. Cobble grouted spillway. [Additional Reference(s): DWR Levee Log, 1987. USACE San Joaquin O&M Manual 612.2, 1967, (HLM 1.45) and 612 (addendum), February 1999, (HLM 1.45) (Station 76+42)].
FS Date: 6/19/2014

Concrete headwall on LS toe.

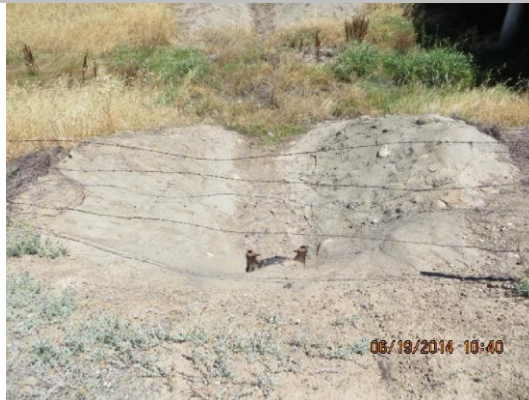
Photo 2 of 3 : UCIP_FA_2017_38977_71063.jpg

Pipe, flapgate, and grouted spillway on WS toe.

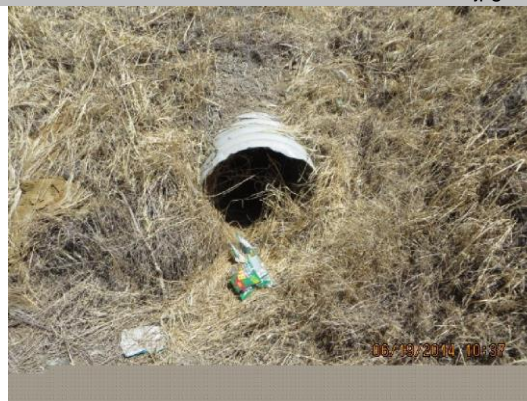
Photo 2 of 3 : UCIP_FA_2017_38963_70883.jpg

Pipe visible on LS toe.

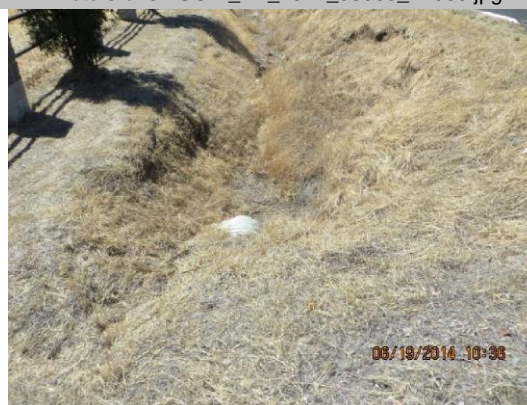
Photo 3 of 3 : UCIP_FA_2017_38963_71060.jpg

Pipe visible on LS toe.

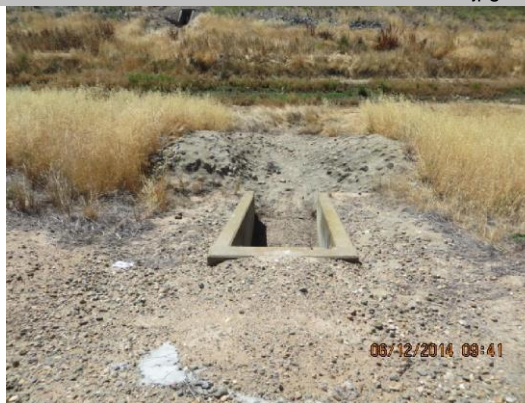
Photo 1 of 3 : UCIP_FA_2017_38567_70661.jpg

LM Start	0.03	Rating **	A/W	Issue No.	13
LM End	0.03	Issue Type +	Ma	Location *	
Category	Supplemental			GPS Latitude/Longitude	
				Start	End
Item	DWR UCIP LMA Responsibility			38.094170 °	38.094170 °
				-121.175555 °	-121.175555 °
DWR ID					
Comment Code					
Inspector Comment					
FS_ID:38567 DS_ID:23859 EP_NO: N/A Repair Type: No Action Needed Crossing Status: Found UCIP Comments: FIELD_STRUCT_DESC: 36-inch corrugated metal drainage pipe through the levee, 7 feet below the crown. Concrete U-shaped headwall on both ends. Flap gate on the waterside (WS) end. Cobble grouted spillway. Cobble grouted intake on the landside (LS). [Additional Reference(s): DWR Levee Log, 1978. USACE San Joaquin O&M Manual 612.2, 1967, (HLM 0.03)]. FS Date: 6/12/2014

Headwall, flapgate, and grouted spillway on WS slope.

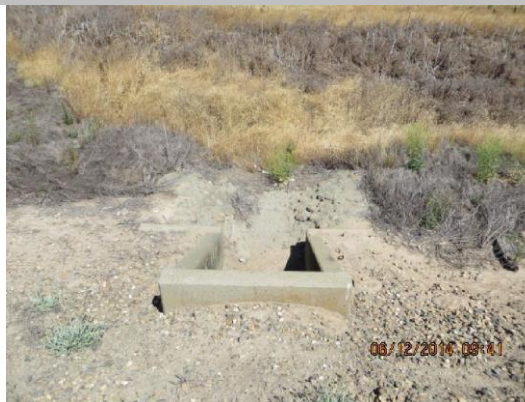
Photo 2 of 3 : UCIP_FA_2017_38567_70660.jpg

Headwall at LS toe.

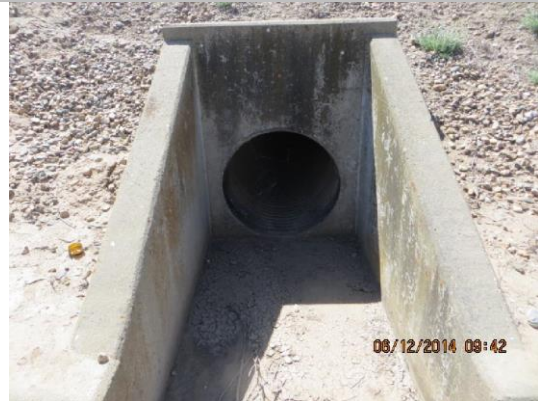
Photo 3 of 3 : UCIP_FA_2017_38567_70659.jpg

Headwall at LS toe.

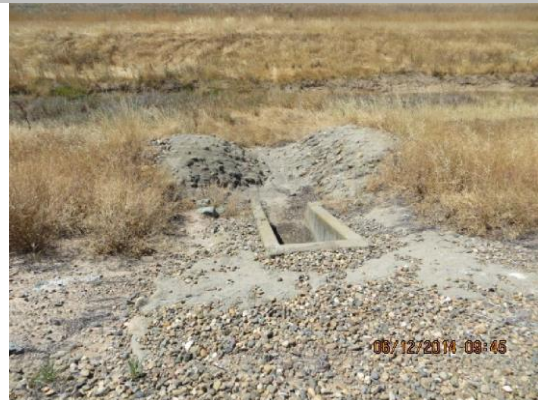
Photo 1 of 3 : UCIP_FA_2017_38568_70666.jpg

LM Start	0.24	Rating **	A/W	Issue No.	14
LM End	0.24	Issue Type +	Ma	Location *	
Category	Supplemental			GPS Latitude/Longitude	
				Start	End
Item	DWR UCIP LMA Responsibility			38.094879 °	38.094879 °
				-121.171734 °	-121.171734 °
DWR ID					
Comment Code					
Inspector Comment					
FS_ID:38568 DS_ID:23860 EP_NO: N/A Repair Type: No Action Needed Crossing Status: Found UCIP Comments: FIELD_STRUCT_DESC: 24-inch corrugated metal drainage pipe through the levee, 7 feet below the crown. Concrete U-shaped headwall on both ends. Flap gate on the waterside (WS) end. Cobble grouted spillway. Cobble grouted intake on the landside (LS). [Additional Reference(s): DWR Levee Log, 1978. USACE San Joaquin O&M Manual 612.2, 1967, (HLM 0.24)]. FS Date: 6/12/2014

Headwall, flapgate, and grouted spillway on WS slope.

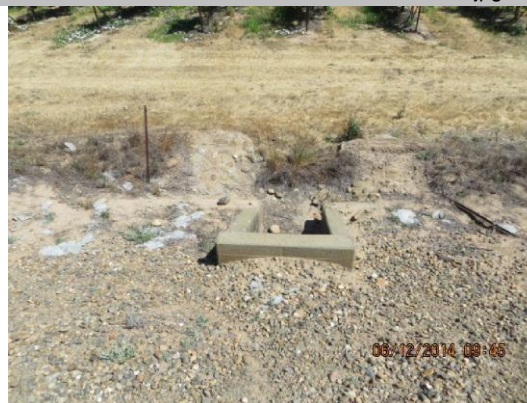
Photo 2 of 3 : UCIP_FA_2017_38568_70665.jpg

Headwall at LS toe.

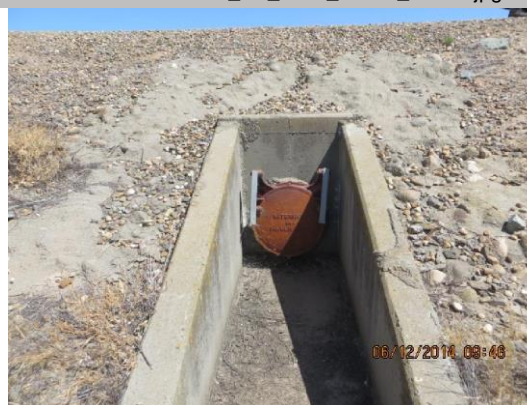
Photo 3 of 3 : UCIP_FA_2017_38568_70664.jpg

Headwall and flapgate on WS slope.

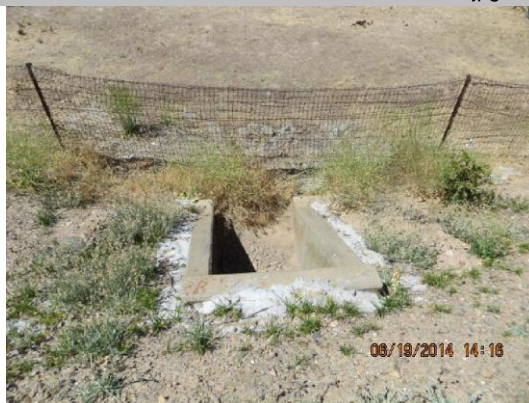
Photo 1 of 3 : UCIP_FA_2017_38994_71165.jpg

FS_ID:38994
DS_ID:23861
EP_NO: N/A
Repair Type: No Action Needed
Crossing Status: Found
UCIP Comments:
FIELD_STRUCT_DESC: 24-inch corrugated metal drainage pipe through the levee, 5 feet below the crown. Concrete U-shaped headwall on both ends. Flap gate on the waterside (WS) end. Cobble grouted spillway. Cobble grouted intake on the landside (LS). [Additional Reference(s): DWR Levee Log, 1978. USACE San Joaquin O&M Manual 612.2, 1967, (HLM 0.36)].
FS Date: 6/19/2014

Pipe and headwall on LS toe.

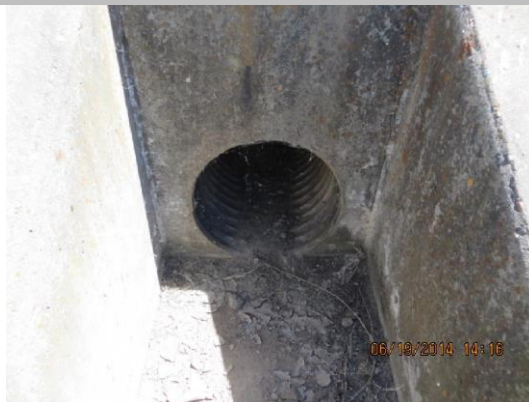
Photo 2 of 3 : UCIP_FA_2017_38994_71164.jpg

Pipe and headwall on LS toe.

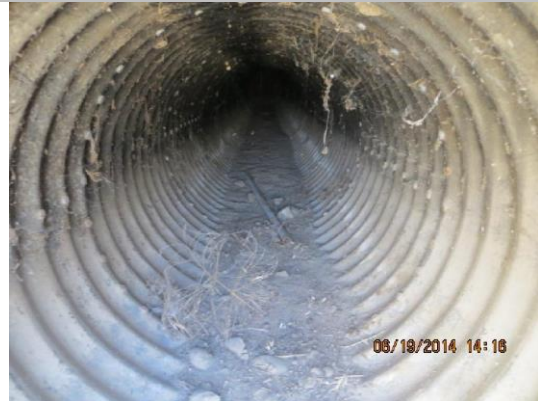
Photo 3 of 3 : UCIP_FA_2017_38994_71163.jpg

Inside pipe at LS toe.

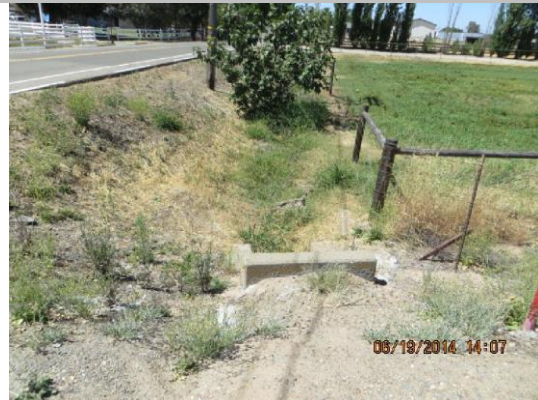
Photo 1 of 3 : UCIP_FA_2017_38992_71158.jpg

LM Start	0.45	Rating **	A/W	Issue No.	16
LM End	0.45	Issue Type +	Ma	Location *	
Category	Supplemental			GPS Latitude/Longitude	
				Start	End
Item	DWR UCIP LMA Responsibility			38.095271 °	38.095271 °
				-121.166654 °	-121.166654 °
DWR ID					
Comment Code					
Inspector Comment					
FS_ID:38992 DS_ID:23863 EP_NO: N/A Repair Type: No Action Needed Crossing Status: Found UCIP Comments: FIELD_STRUCT_DESC: 24-inch corrugated metal drainage pipe through the levee, 4 feet below the crown. Concrete U-shaped headwall on both ends. Flap gate on the waterside (WS) end. Cobble grouted spillway. Cobble grouted intake on the landside (LS). [Additional Reference(s): DWR Levee Log, 1978. USACE San Joaquin O&M Manual 612.2, 1967, (HLM 0.46)]. FS Date: 6/19/2014

Pipe and headwall on LS toe.

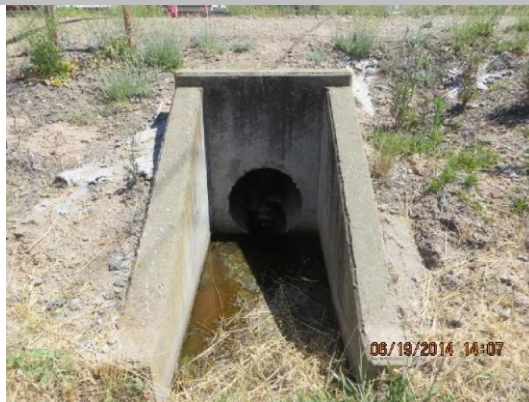
Photo 3 of 3 : UCIP_FA_2017_38992_71156.jpg

Pipe and headwall on LS toe.

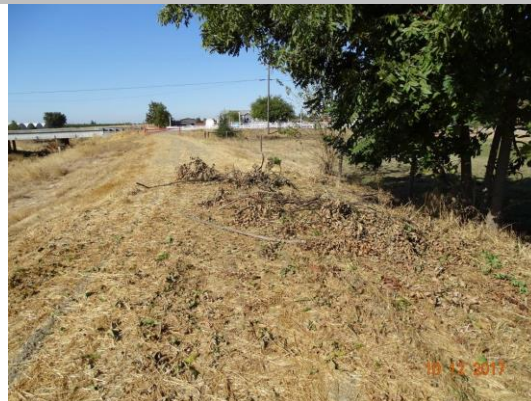
Photo 1 of 1 : FA_2017_NA0017_154_12_20171016_00059.jpg

LM Start	0.49	Rating **	M	Issue No.	12
LM End	0.49	Issue Type +	Ma	Location *	CR
Category	Earthen Levee			GPS Latitude/Longitude	
				Start	End
Item	Encroachments			38.095304 °	38.095304 °
				-121.165945 °	-121.165945 °
DWR ID	DWR_NA0017_10_f_2017_12				
Comment Code					
PR : Prunings					
Inspector Comment

View of prunings on the crown of the levee. Fall 2017

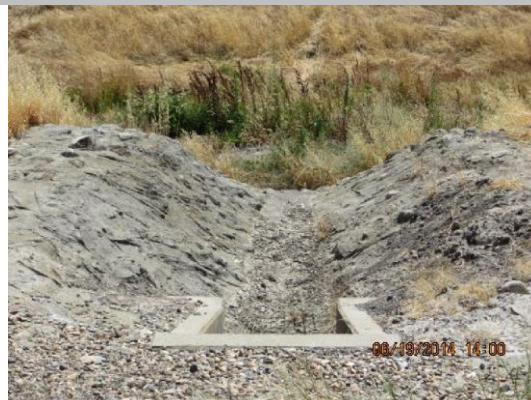
Photo 1 of 3 : UCIP_FA_2017_38990_71153.jpg

Comment Code					
Inspector Comment					
FS_ID:38990 DS_ID:23864 EP_NO: N/A Repair Type: No Action Needed Crossing Status: Found UCIP Comments: FIELD_STRUCT_DESC: 24-inch corrugated metal drainage pipe through the levee, 5 feet below the crown. Concrete U-shaped headwall on both ends. Flap gate on the waterside (WS) end. Cobble grouted spillway. Cobble grouted intake on the landside (LS). (Temporary 3-inch polyvinyl chloride drainage pipe sleeved through drainage pipe with portable LS pump under Permit No. 11617, 1976 - Tom Patterson). [Additional Reference(s): DWR Levee Log, 1978. USACE San Joaquin O&M Manual 612.2, 1967, (HLM 0.58)]. FS Date: 6/19/2014

Pipe, headwall, flapgate, and grouted spillway on WS toe.

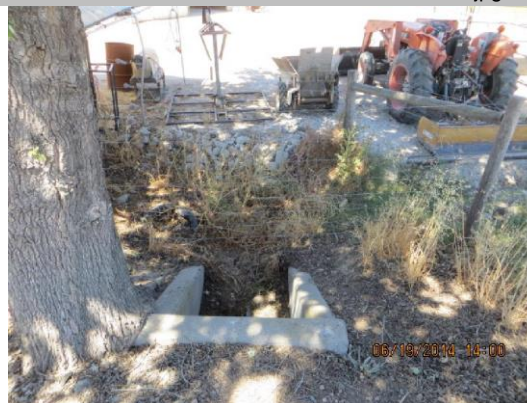
Photo 2 of 3 : UCIP_FA_2017_38990_71152.jpg

Pipe and headwall on LS toe.

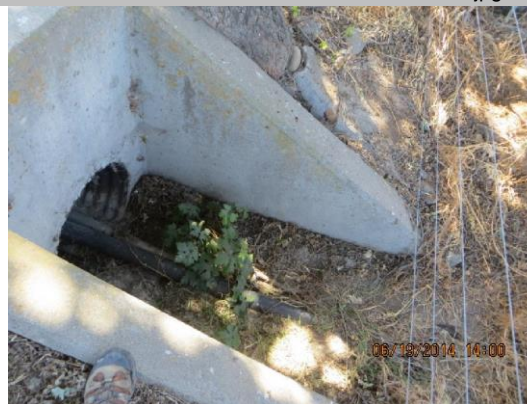
Photo 3 of 3 : UCIP_FA_2017_38990_71151.jpg

Pipe and headwall on LS toe.

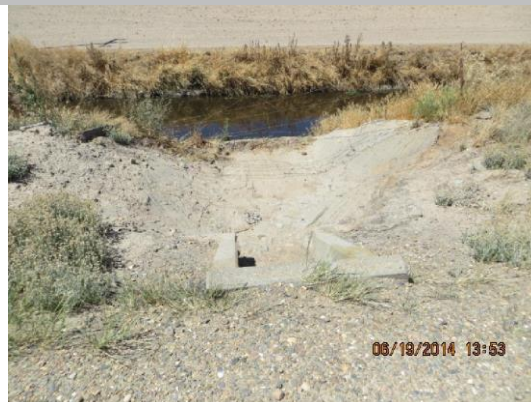
Photo 2 of 3 : UCIP_FA_2017_38989_71147.jpg

Pipe and headwall on LS toe.

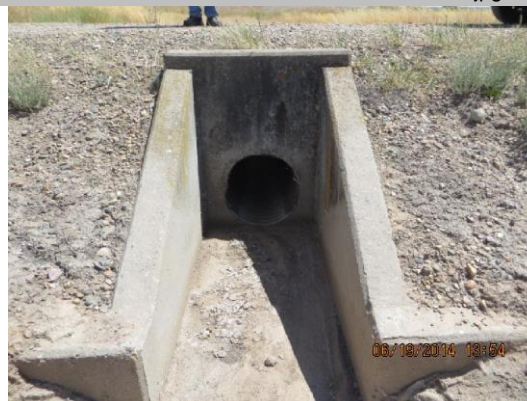
Photo 3 of 3 : UCIP_FA_2017_38989_71146.jpg

Pipe and headwall on LS toe.

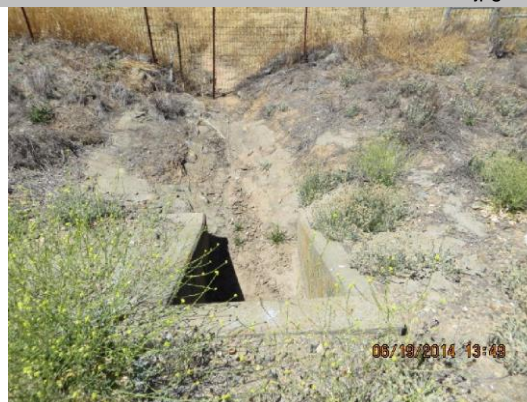
Photo 1 of 3 : UCIP_FA_2017_38988_71144.jpg

Pipe and headwall on LS toe.

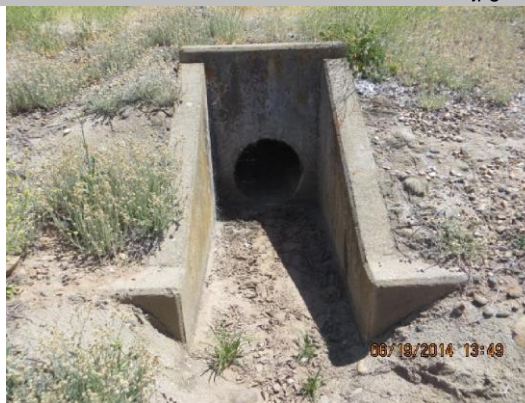
Photo 2 of 3 : UCIP_FA_2017_38988_71143.jpg

Pipe and headwall on LS toe.

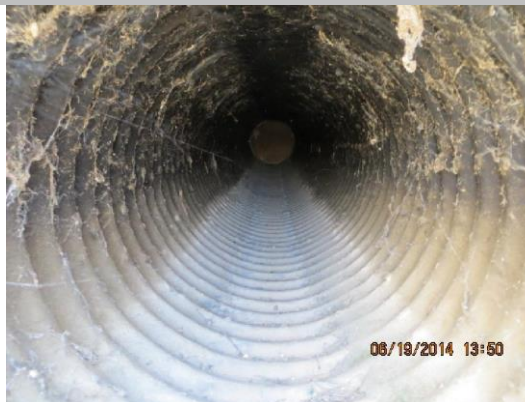
Photo 3 of 3 : UCIP_FA_2017_38988_71142.jpg

Inside pipe at LS toe.

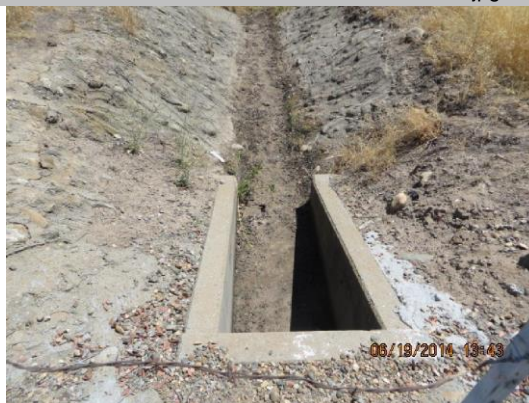
Photo 1 of 3 : UCIP_FA_2017_38987_71139.jpg

Pipe, headwall, flapgate, and grouted spillway on WS toe.

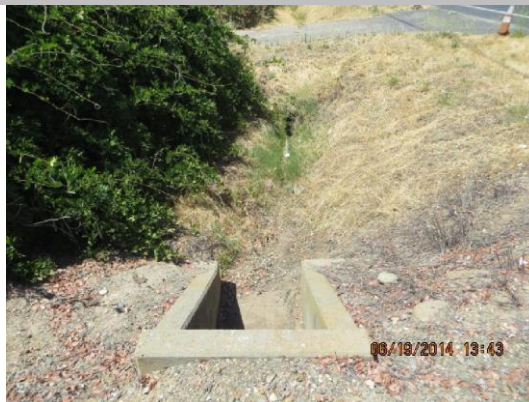
Photo 2 of 3 : UCIP_FA_2017_38987_71138.jpg

Pipe and headwall on LS toe.

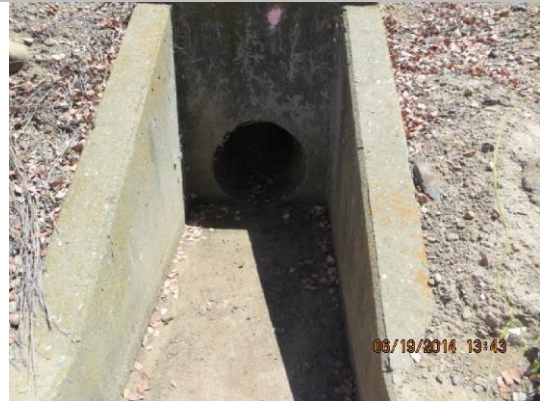
Photo 3 of 3 : UCIP_FA_2017_38987_71137.jpg

Pipe and headwall on LS toe.

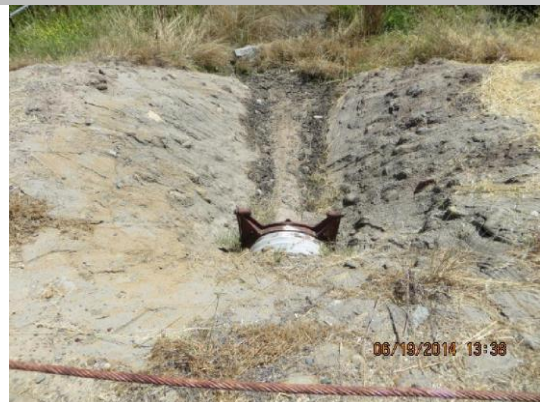
Photo 1 of 3 : UCIP_FA_2017_51721_71134.jpg

Comment Code					
Inspector Comment					
FS_ID:51721 DS_ID:23868 EP_NO: N/A Repair Type: No Action Needed Crossing Status: Found UCIP Comments: 04/28/2017 Crossing has been downgraded from Non-Urgent to No Action Needed, since sediment buildup is only minimal. (K. Fazel - UCIP)06/19/2014 Some sediment buildup in pipe at LS toe. (G. Wylie - FPIIB) FIELD_STRUCT_DESC: 30-inch corrugated metal drainage pipe through the levee, 6 feet below the crown. Flap gate on the waterside (WS) end. Cobble grouted spillway. Cobble grouted intake on the landside (LS). [Additional Reference(s): DWR Levee Log, 1978. USACE San Joaquin O&M Manual 612.2, 1967, (HLM 1.35)]. FS Date: 6/19/2014

Pipe, flapgate, and grouted spillway on WS toe.

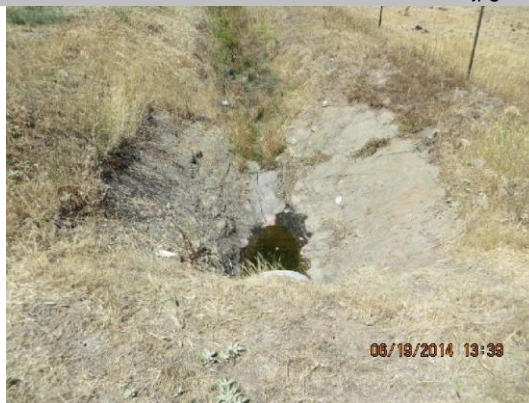
Photo 2 of 3 : UCIP_FA_2017_51721_71133.jpg

Pipe on LS toe.

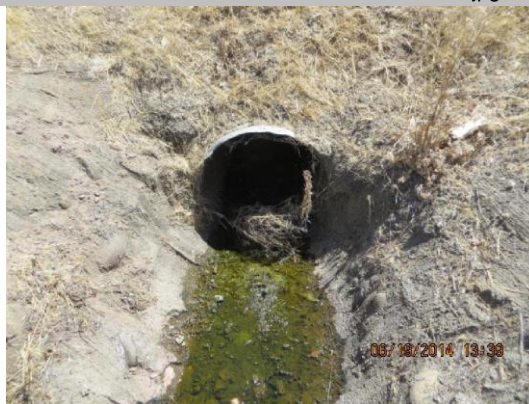
Photo 3 of 3 : UCIP_FA_2017_51721_71133.jpg

Pipe on LS toe.

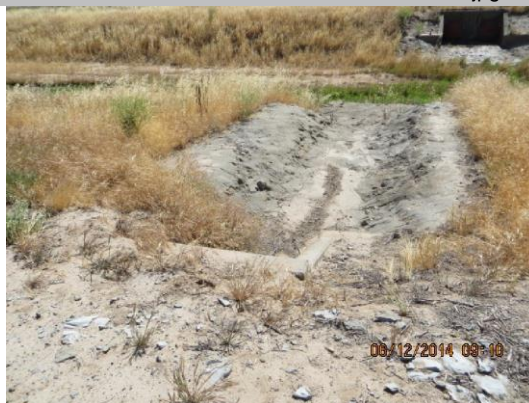
Photo 1 of 3 : UCIP_FA_2017_38566_70656.jpg

Headwall, flapgate, and grouted spillway on WS slope.

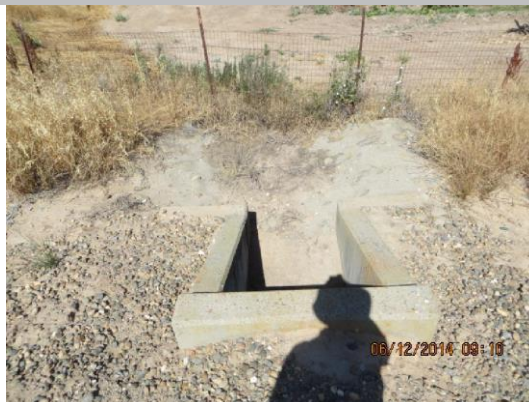
Photo 2 of 3 : UCIP_FA_2017_38566_70655.jpg

Headwall at LS toe.

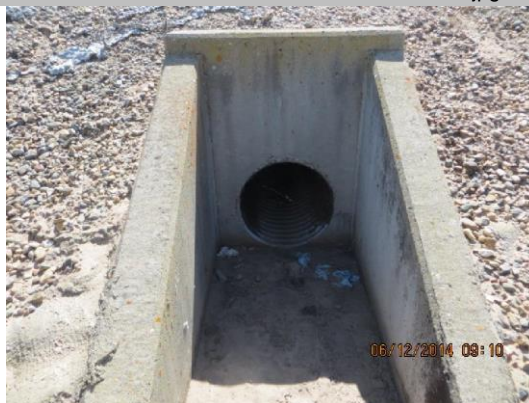
Photo 3 of 3 : UCIP_FA_2017_38566_70654.jpg

Headwall at LS toe.
