**Flood Control Project Maintenance
Levee Inspections**

Maintenance Issue Types Only, Levee Inspection Report By Mile - Fall 2017

San Joaquin County Flood Control and Water Conservation District

Waterway	Bank	Unit Miles	Inspection Start/End	Inspector
Unit No. 01 Littlejohn Creek	Left	2.59	10/17/2017 10/17/2017	Pavel Kazi

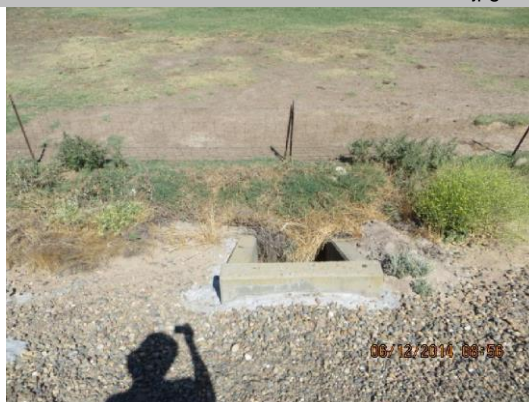
Photo 1 of 3 : UCIP_FA_2017_38565_70651.jpg

Headwall at LS toe.

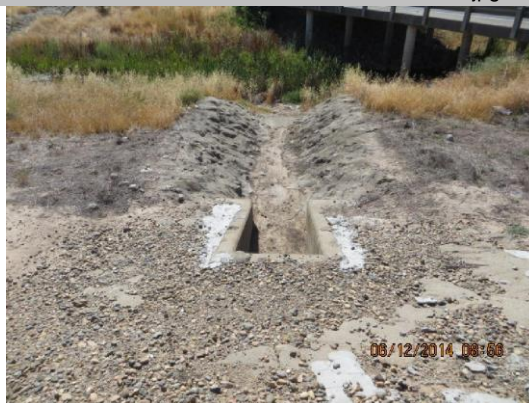
Photo 2 of 3 : UCIP_FA_2017_38565_70650.jpg

Headwall, flapgate, and grouted spillway on WS slope.

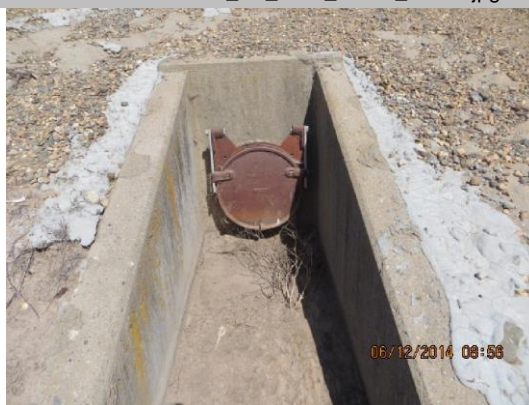
Photo 3 of 3 : UCIP_FA_2017_38565_70649.jpg

Headwall and flapgate on WS slope.

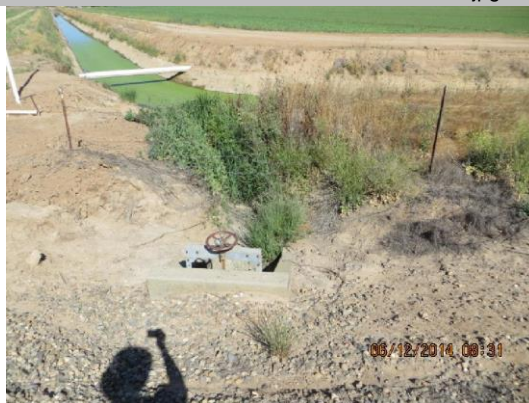
Photo 1 of 3 : UCIP_FA_2017_38559_70621.jpg

Headwall and slidegate on LS toe.

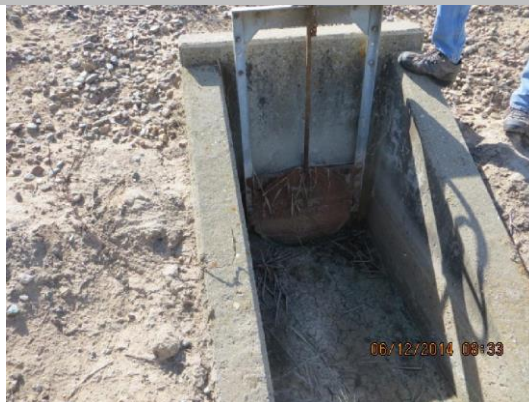
Photo 2 of 3 : UCIP_FA_2017_38559_70620.jpg

Headwall and slidegate on LS toe.

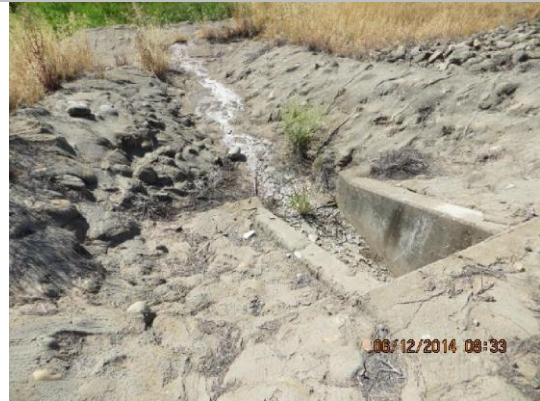
Photo 3 of 3 : UCIP_FA_2017_38559_70623.jpg

Headwall, flapgate, and grouted spillway on WS slope.

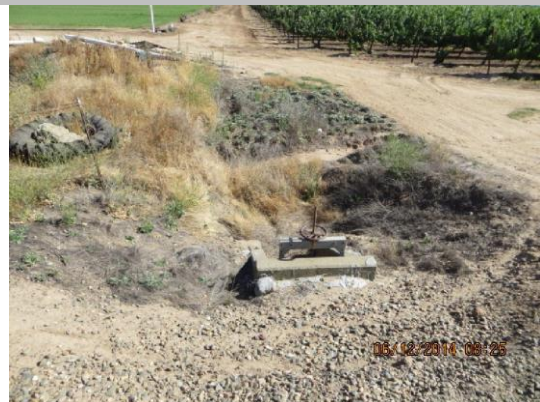
Photo 1 of 3 : UCIP_FA_2017_38558_70618.jpg

Headwall and slidegate on LS toe.

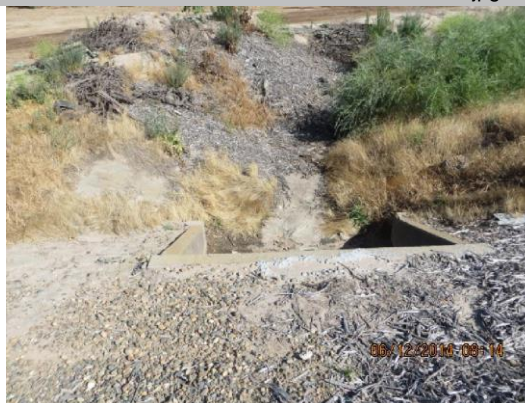
Photo 1 of 3 : UCIP_FA_2017_38557_70613.jpg

FS_ID:38557
DS_ID:23871
EP_NO: N/A
Repair Type: Non-Urgent
Crossing Status: Found
UCIP Comments: Slidegate may be rusted shut or does not function. Heavy sediment buildup in pipe. Lid on CMP riser needs repair.
FIELD_STRUCT_DESC: 1 of 2: 36-inch corrugated metal drainage pipe through the levee, 7 feet below the crown. Slide gate in 48-inch corrugated metal riser unit on the waterside (WS) slope. Concrete U-shaped headwall on both ends. Flap gate on the WS end. Cobble grouted spillway. Cobble grouted intake on the landside (LS).
[Additional Reference(s): DWR Levee Log, 1978. USACE San Joaquin O&M Manual 612.2, 1967, (HLM 1.51)].
FS Date: 6/12/2014

Headwall at LS toe.

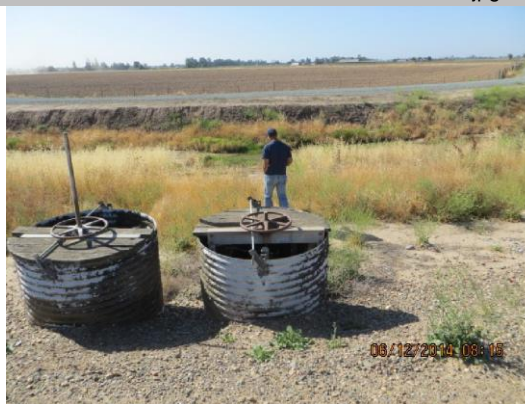
Photo 2 of 3 : UCIP_FA_2017_38557_70612.jpg

Slidegate inside CMP riser on WS shoulder. Lid needs repair.

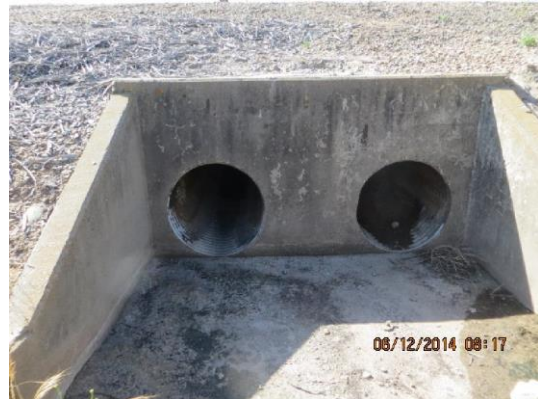
Photo 3 of 3 : UCIP_FA_2017_38557_70611.jpg

Comment Code						
Inspector Comment						
FS_ID:38557						
DS_ID:23871						
EP_NO: N/A						
Repair Type: Non-Urgent						
Crossing Status: Found						
UCIP Comments: Slidegate may be rusted shut or does not function.						
Heavy sediment buildup in pipe. Lid on CMP riser needs repair.						
FIELD_STRUCT_DESC: 1 of 2: 36-inch corrugated metal drainage pipe						
through the levee, 7 feet below the crown. Slide gate in 48-inch						
corrugated metal riser unit on the waterside (WS) slope. Concrete U-						
shaped headwall on both ends. Flap gate on the WS end. Cobble						
grouted spillway. Cobble grouted intake on the landside (LS).						
[Additional Reference(s): DWR Levee Log, 1978. USACE San Joaquin						
O&M Manual 612.2, 1967, (HLM 1.51)].						
FS Date: 6/12/2014

Headwall at LS toe.

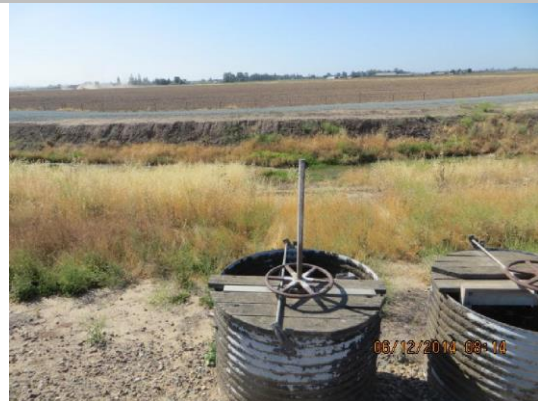
Photo 1 of 3 : UCIP_FA_2017_38556_70608.jpg

Comment Code					
Inspector Comment					
FS_ID:38556 DS_ID:23897 EP_NO: N/A Repair Type: Non-Urgent Crossing Status: Found UCIP Comments: Slidegate not functional or rusted in place. No lid on CMP riser at WS slope. FIELD_STRUCT_DESC: 2 of 2: 36-inch corrugated metal drainage pipe through the levee, 7 feet below the crown. Slide gate in 48-inch corrugated metal riser unit on the waterside (WS) slope. Concrete U- shaped headwall on both ends. Flap gate on the WS end. Cobble grouted spillway. Cobble grouted intake on the landside (LS). [Additional Reference(s): DWR Levee Log, 1978. USACE San Joaquin O&M Manual 612.2, 1967, (HLM 1.51)]. FS Date: 6/12/2014

Slidegate in CMP riser on WS shoulder. No lid and gateavle does not work.

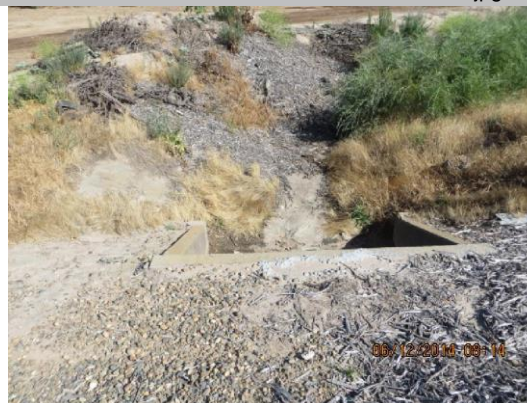
Photo 2 of 3 : UCIP_FA_2017_38556_70607.jpg

FS_ID:38556
DS_ID:23897
EP_NO: N/A
Repair Type: Non-Urgent
Crossing Status: Found
UCIP Comments: Slidegate not functional or rusted in place. No lid on CMP riser at WS slope.
FIELD_STRUCT_DESC: 2 of 2: 36-inch corrugated metal drainage pipe through the levee, 7 feet below the crown. Slide gate in 48-inch corrugated metal riser unit on the waterside (WS) slope. Concrete U-shaped headwall on both ends. Flap gate on the WS end. Cobble grouted spillway. Cobble grouted intake on the landside (LS).
[Additional Reference(s): DWR Levee Log, 1978. USACE San Joaquin O&M Manual 612.2, 1967, (HLM 1.51)].
FS Date: 6/12/2014

Headwall at LS toe.

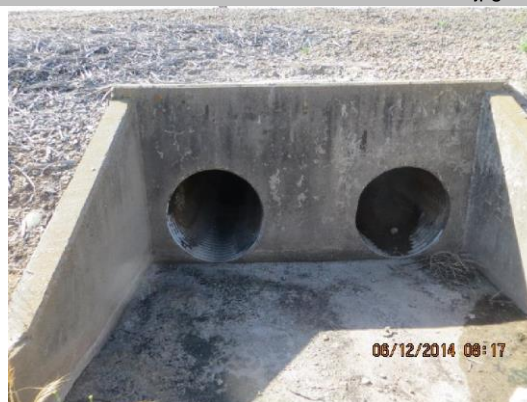
Photo 3 of 3 : UCIP_FA_2017_38556_70606.jpg

Headwall at LS toe.

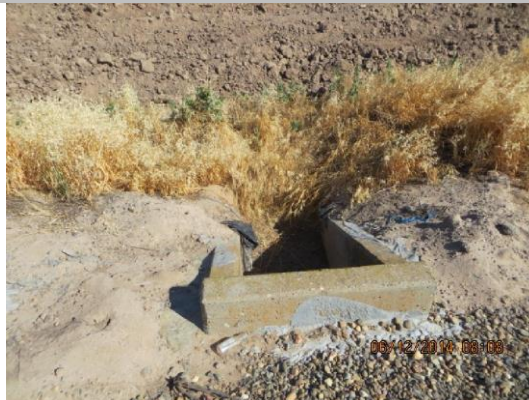
Photo 2 of 3 : UCIP_FA_2017_38555_70602.jpg

Headwall at LS toe.

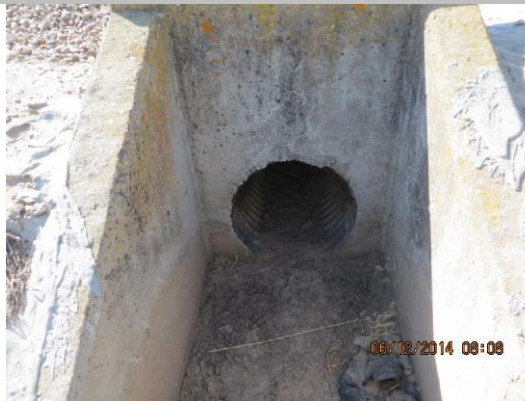
Photo 3 of 3 : UCIP_FA_2017_38555_70601.jpg

LM Start	1.81	Rating **	A/W	Issue No.	216 (cont)	
LM End	1.81	Issue Type +	Ma	Location *		
Category	Supplemental			GPS Latitude/Longitude		
				Start		End
Item	DWR UCIP LMA Responsibility			38.114551 °		38.114551 °
				-121.156224 °		-121.156224 °
DWR ID						
Comment Code						
Inspector Comment						
FS_ID:38555 DS_ID:23872 EP_NO: N/A Repair Type: No Action Needed Crossing Status: Found UCIP Comments: FIELD_STRUCT_DESC: 24-inch corrugated metal drainage pipe through the levee, 5.5 feet below the crown. Concrete U-shaped headwall on both ends. Flap gate on the waterside (WS) end. Cobble grouted spillway. Cobble grouted intake on the landside (LS). [Additional Reference(s): DWR Levee Log, 1978. USACE San Joaquin O&M Manual 612.2, 1967, (HLM 1.82)]. FS Date: 6/12/2014

Headwall at LS toe.

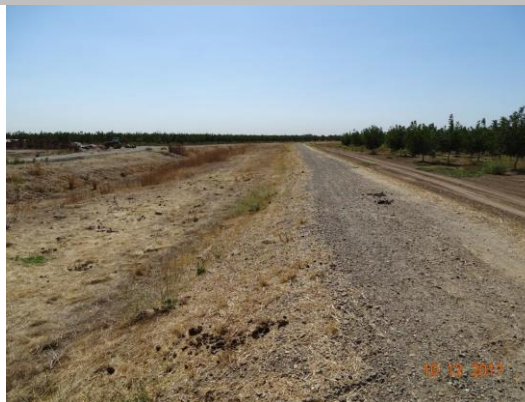
Photo 1 of 1 : FA_2017_NA0017_155_40_20171016_00163.jpg

LM Start	1.98	Rating **	A	Issue No.	40
LM End	1.98	Issue Type +	Ma	Location *	WS
Category	Earthen Levee			GPS Latitude/Longitude	
				Start	End
Item	Vegetation			38.116630 °	38.116630 °
				-121.154661 °	-121.154661 °
DWR ID	DWR_NA0017_11_f_2017_40				
Comment Code					
V1 : Control annual grass and weeds on the levee slopes and easements.					
Inspector Comment					
Acceptable vegetation.

View of the waterside slope of the levee. Fall 2017

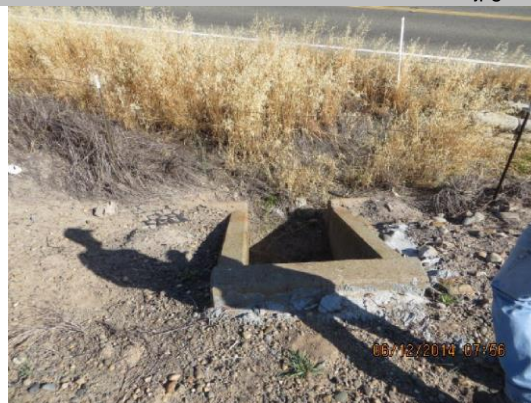
Photo 1 of 3 : UCIP_FA_2017_38552_70590.jpg

LM Start	2.04	Rating **	A/W	Issue No.	218	
LM End	2.04	Issue Type +	Ma	Location *		
Category	Supplemental			GPS Latitude/Longitude		
				Start		End
Item	DWR UCIP LMA Responsibility			38.117176 °		38.117176 °
				-121.154019 °		-121.154019 °
DWR ID						
Comment Code						
Inspector Comment						
FS_ID:38552						
DS_ID:23874						
EP_NO: N/A						
Repair Type: No Action Needed						
Crossing Status: Found						
UCIP Comments:						
FIELD_STRUCT_DESC: 24-inch corrugated metal drainage pipe through the levee, 6 feet below the crown. Concrete U-shaped headwall on both ends. Flap gate on the waterside (WS) end. Cobble grouted spillway. Cobble grouted intake on the landside (LS). [Additional Reference(s): DWR Levee Log, 1978. USACE San Joaquin O&M Manual 612.2, 1967, (HLM 2.05)].						
FS Date: 6/12/2014

Headwall at LS toe.

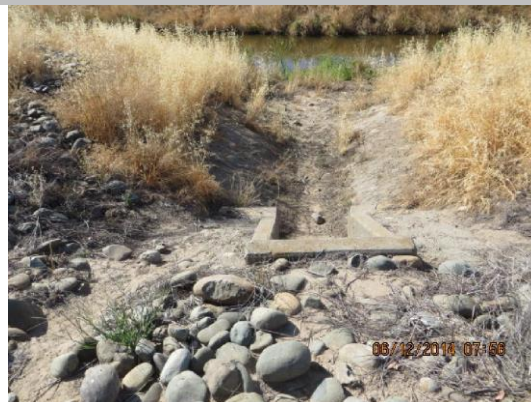
Photo 2 of 3 : UCIP_FA_2017_38552_70589.jpg

Headwall, flapgate, and grouted spillway on WS slope.

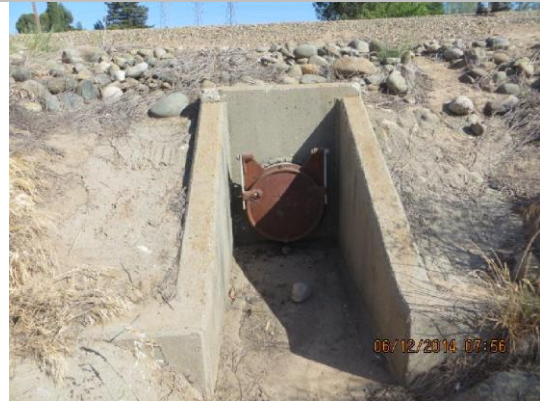
Photo 3 of 3 : UCIP_FA_2017_38552_70588.jpg

LM Start	2.04	Rating **	A/W	Issue No.	218 (cont)
LM End	2.04	Issue Type +	Ma	Location *	
Category	Supplemental			GPS Latitude/Longitude	
				Start	End
Item	DWR UCIP LMA Responsibility			38.117176 °	38.117176 °
				-121.154019 °	-121.154019 °
DWR ID					
Comment Code					
Inspector Comment					
FS_ID:38552 DS_ID:23874 EP_NO: N/A Repair Type: No Action Needed Crossing Status: Found UCIP Comments: FIELD_STRUCT_DESC: 24-inch corrugated metal drainage pipe through the levee, 6 feet below the crown. Concrete U-shaped headwall on both ends. Flap gate on the waterside (WS) end. Cobble grouted spillway. Cobble grouted intake on the landside (LS). [Additional Reference(s): DWR Levee Log, 1978. USACE San Joaquin O&M Manual 612.2, 1967, (HLM 2.05)]. FS Date: 6/12/2014

Headwall and flapgate on WS slope.

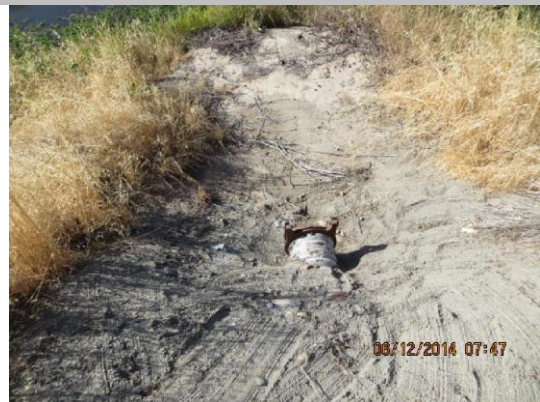
Photo 1 of 3 : UCIP_FA_2017_38551_70586.jpg

LM Start	2.12	Rating **	A/W	Issue No.	219
LM End	2.12	Issue Type +	Ma	Location *	
Category	Supplemental			GPS Latitude/Longitude	
				Start	End
Item	DWR UCIP LMA Responsibility			38.117580 °	38.117580 °
				-121.152490 °	-121.152490 °
DWR ID					
Comment Code					
Inspector Comment					
FS_ID:38551					
DS_ID:23875					
EP_NO: N/A					
Repair Type: No Action Needed					
Crossing Status: Found					
UCIP Comments:					
FIELD_STRUCT_DESC: 12-inch corrugated metal drainage pipe through the levee, 5.5 feet below the crown. Flap gate on the waterside (WS) end. Drop inlet with grate at the landside (LS) toe. Spillway cobble grouted. [Additional Reference(s): DWR Levee Log, 1978. USACE San Joaquin O&M Manual 612.2, 1967, (HLM 2.14)].					
FS Date: 6/12/2014

Grouted outlet showing pipe and flapgate on WS slope.

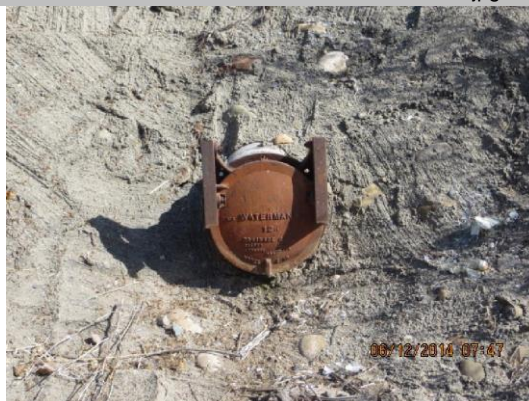
Photo 2 of 3 : UCIP_FA_2017_38551_70585.jpg

LM Start	2.12	Rating **	A/W	Issue No.	219 (cont)	
LM End	2.12	Issue Type +	Ma	Location *		
Category	Supplemental			GPS Latitude/Longitude		
				Start		End
Item	DWR UCIP LMA Responsibility			38.117580 °		38.117580 °
				-121.152490 °		-121.152490 °
DWR ID						
Comment Code						
Inspector Comment						
FS_ID:38551						
DS_ID:23875						
EP_NO: N/A						
Repair Type: No Action Needed						
Crossing Status: Found						
UCIP Comments:						
FIELD_STRUCT_DESC: 12-inch corrugated metal drainage pipe through the levee, 5.5 feet below the crown. Flap gate on the waterside (WS) end. Drop inlet with grate at the landside (LS) toe. Spillway cobble grouted. [Additional Reference(s): DWR Levee Log, 1978. USACE San Joaquin O&M Manual 612.2, 1967, (HLM 2.14)].						
FS Date: 6/12/2014

Grouted outlet showing pipe and flapgate on WS slope.

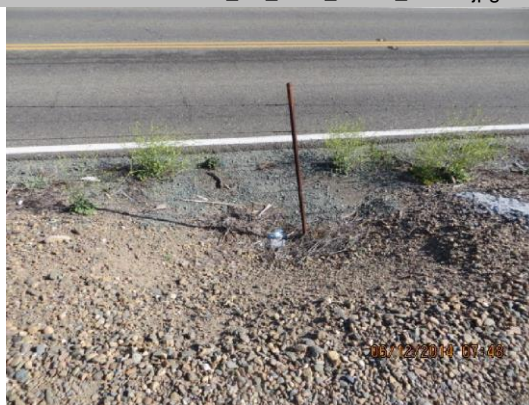
Photo 3 of 3 : UCIP_FA_2017_38551_70584.jpg

Grate over drop-inlet at LS toe next to T-post.

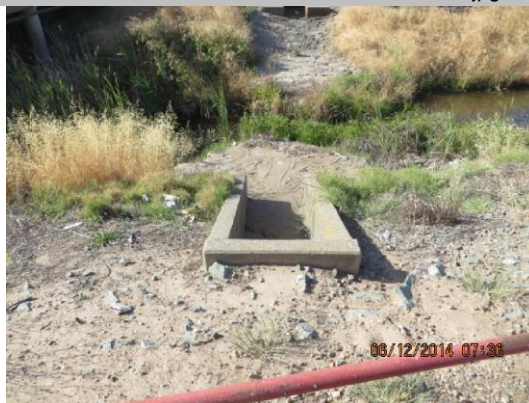
Photo 1 of 3 : UCIP_FA_2017_38550_70583.jpg

LM Start	2.20	Rating **	M	Issue No.	220
LM End	2.20	Issue Type +	Ma	Location *	
Category	Supplemental			GPS Latitude/Longitude	
				Start	End
Item	DWR UCIP LMA Responsibility			38.117920 °	38.117920 °
				-121.151120 °	-121.151120 °
DWR ID					
Comment Code					
Inspector Comment					
FS_ID:38550 DS_ID:23876 EP_NO: N/A Repair Type: Non-Urgent Crossing Status: Found UCIP Comments: Concrete inlet at LS of East Kettleman road is damaged...may or may not be a hazard. FIELD_STRUCT_DESC: 24-inch corrugated metal drainage pipe through the levee, 5 feet below the crown. Concrete U-shaped headwall on the waterside (WS) end. Flap gate on the WS end. Cobble grouted spillway. 36-inch concrete catch basin on the landside (LS) end. [Additional Reference(s): DWR Levee Log, 1978. USACE San Joaquin O&M Manual 612.2, 1967, (HLM 2.22)]. FS Date: 6/12/2014

Headwall, flapgate, and grouted spillway on WS slope.

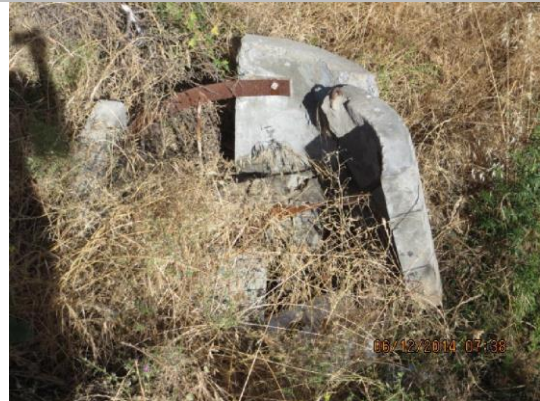
Photo 3 of 3 : UCIP_FA_2017_38550_70581.jpg

LM Start	2.20	Rating **	M	Issue No.	220 (cont)
LM End	2.20	Issue Type +	Ma	Location *	
Category	Supplemental			GPS Latitude/Longitude	
				Start	End
Item	DWR UCIP LMA Responsibility			38.117920 °	38.117920 °
				-121.151120 °	-121.151120 °
DWR ID					
Comment Code					
Inspector Comment					
FS_ID:38550 DS_ID:23876 EP_NO: N/A Repair Type: Non-Urgent Crossing Status: Found UCIP Comments: Concrete inlet at LS of East Kettleman road is damaged...may or may not be a hazard. FIELD_STRUCT_DESC: 24-inch corrugated metal drainage pipe through the levee, 5 feet below the crown. Concrete U-shaped headwall on the waterside (WS) end. Flap gate on the WS end. Cobble grouted spillway. 36-inch concrete catch basin on the landside (LS) end. [Additional Reference(s): DWR Levee Log, 1978. USACE San Joaquin O&M Manual 612.2, 1967, (HLM 2.22)]. FS Date: 6/12/2014

Concrete drop-inlet on North side of East Kettleman road damaged.

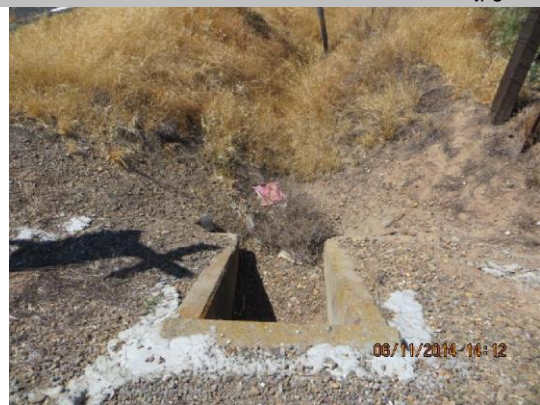
Photo 1 of 3 : UCIP_FA_2017_38548_70576.jpg

LM Start	2.22	Rating **	A/W	Issue No.	223
LM End	2.22	Issue Type +	Ma	Location *	
Category	Supplemental			GPS Latitude/Longitude	
				Start	End
Item	DWR UCIP LMA Responsibility			38.118083 °	38.118083 °
				-121.150782 °	-121.150782 °
DWR ID					
Comment Code					
Inspector Comment					
FS_ID:38548					
DS_ID:23878					
EP_NO: N/A					
Repair Type: No Action Needed					
Crossing Status: Found					
UCIP Comments:					
FIELD_STRUCT_DESC: 24-inch corrugated metal drainage pipe through the levee, 5 feet below the crown. Concrete U-shaped headwall on both ends. Flap gate on the waterside (WS) end. Cobble grouted spillway. Cobble grouted intake on the landside (LS). [Additional Reference(s): DWR Levee Log, 1978. USACE San Joaquin O&M Manual 612.2, 1967, (HLM 2.24)].					
FS Date: 6/11/2014

Headwall at LS toe.

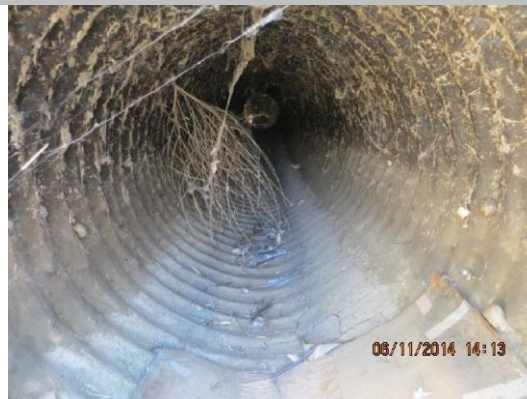
Photo 3 of 3 : UCIP_FA_2017_38548_70574.jpg

Inside pipe at LS toe.

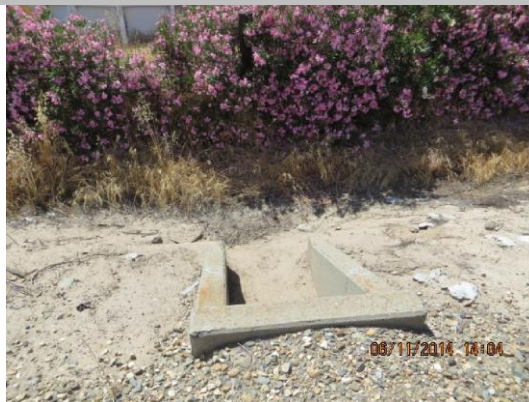
Photo 2 of 3 : UCIP_FA_2017_38546_70570.jpg

Headwall at LS toe.

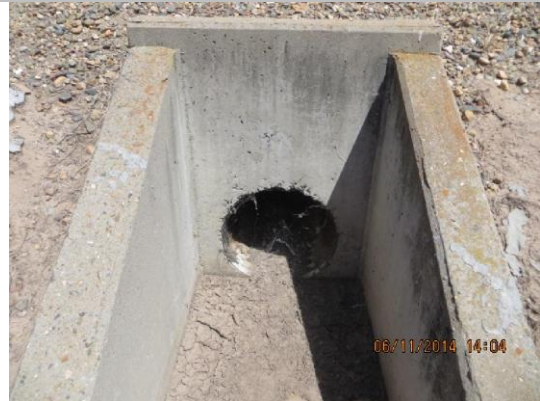
Photo 3 of 3 : UCIP_FA_2017_38546_70569.jpg

LM Start	2.43	Rating **	A/W	Issue No.	224 (cont)	
LM End	2.43	Issue Type +	Ma	Location *		
Category	Supplemental			GPS Latitude/Longitude		
				Start	End	
Item	DWR UCIP LMA Responsibility			38.119587 °	38.119587 °	
				-121.147961 °	-121.147961 °	
DWR ID						
Comment Code						
Inspector Comment						
FS_ID:38546 DS_ID:23886 EP_NO: N/A Repair Type: No Action Needed Crossing Status: Found UCIP Comments: FIELD_STRUCT_DESC: 24-inch corrugated metal drainage pipe through the levee, 4.5 feet below the crown. Concrete U-shaped headwall on both ends. Flap gate on the waterside (WS) end. Cobble grouted spillway. Cobble grouted intake on the landside (LS). [Additional Reference(s): DWR Levee Log, 1978. USACE San Joaquin O&M Manual 612.2, 1967, (HLM 2.44)]. FS Date: 6/11/2014

Headwall at LS toe.

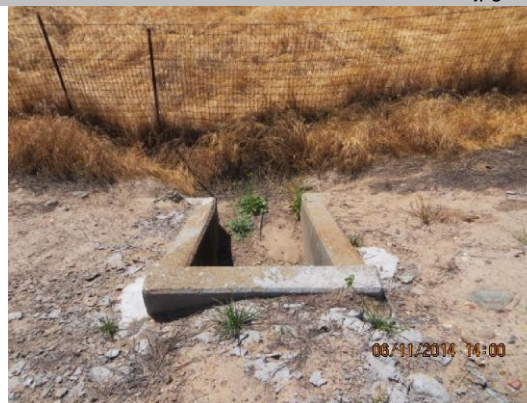
Photo 2 of 3 : UCIP_FA_2017_38545_70565.jpg

Headwall at LS toe.

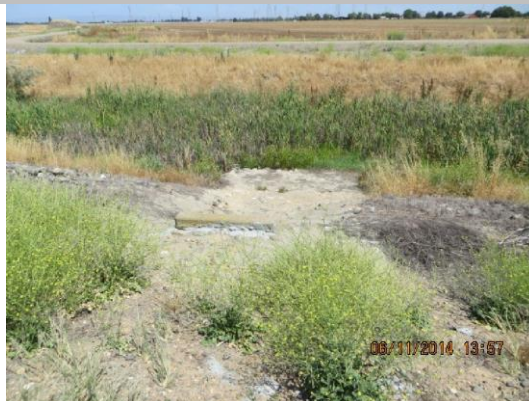
Photo 1 of 3 : UCIP_FA_2017_38544_70561.jpg

Headwall, flapgate, and grouted spillway on WS slope.

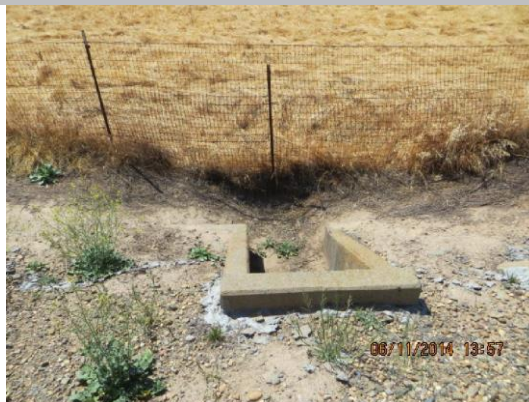
Photo 2 of 3 : UCIP_FA_2017_38544_70560.jpg

Headwall at LS toe.

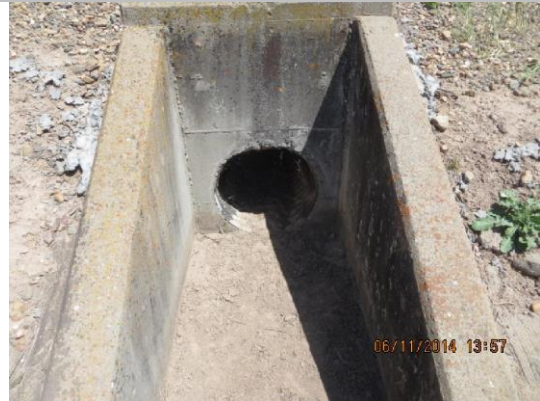
Photo 3 of 3 : UCIP_FA_2017_38544_70559.jpg

Headwall at LS toe.

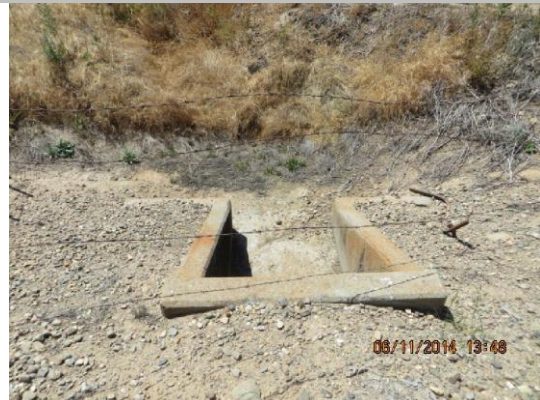
Photo 1 of 3 : UCIP_FA_2017_38542_70554.jpg

Headwall at LS toe.

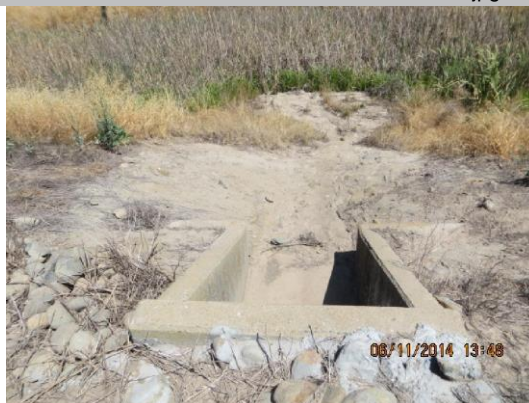
Photo 2 of 3 : UCIP_FA_2017_38542_70553.jpg

Headwall, flapgate, and grouted spillway on WS slope.

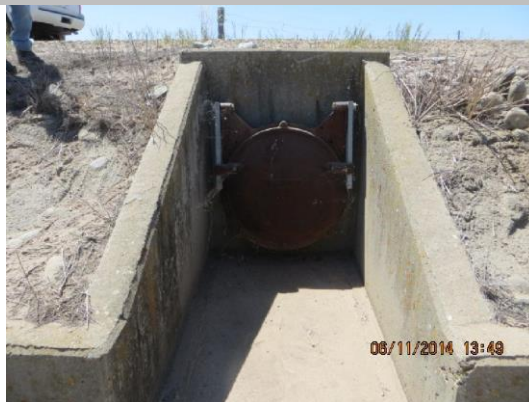
Photo 3 of 3 : UCIP_FA_2017_38542_70552.jpg

Headwall and flapgate on WS slope.

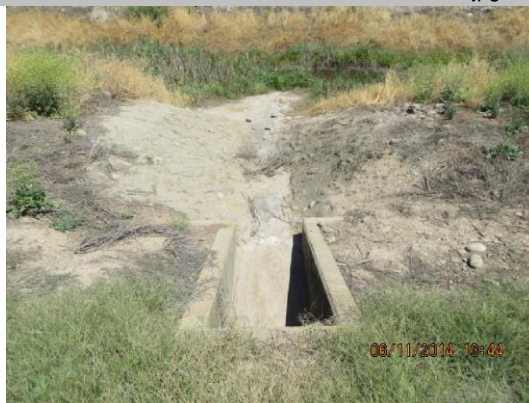
Photo 1 of 3 : UCIP_FA_2017_38541_70550.jpg

Headwall, flapgate, and grouted spillway on WS slope.

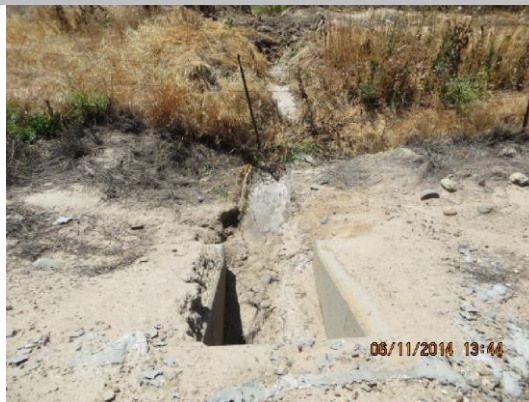
Photo 2 of 3 : UCIP_FA_2017_38541_70549.jpg

Headwall at LS toe.

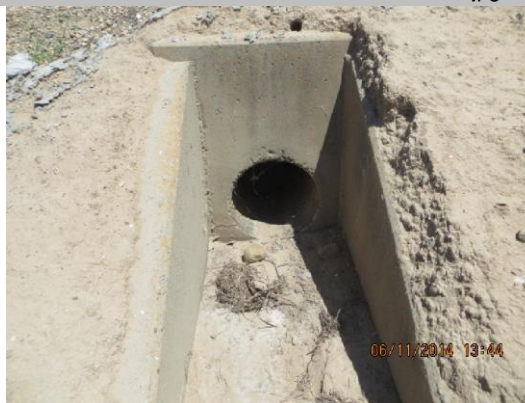
Photo 3 of 3 : UCIP_FA_2017_38541_70548.jpg

Headwall at LS toe.

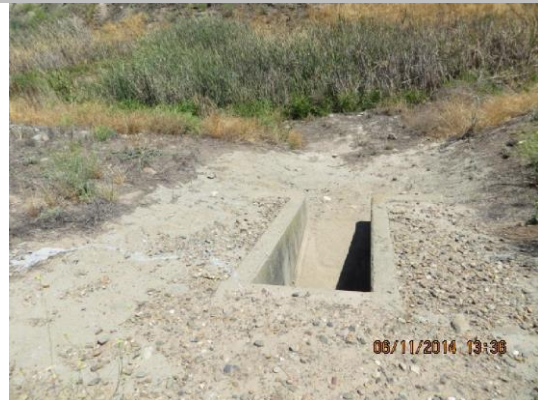
Photo 1 of 3 : UCIP_FA_2017_38539_70546.jpg

Comment Code					
Inspector Comment					
FS_ID:38539 DS_ID:23892 EP_NO: N/A Repair Type: Non-Urgent Crossing Status: Found UCIP Comments: Pipe abandoned and if so should be done so properly. Verify if possible pipe filled with concrete. FIELD_STRUCT_DESC: *ABANDONED* 24-inch corrugated metal drainage pipe through the levee, 6.5 feet below the crown. Concrete U-shaped headwall on both ends. Flap gate on the waterside (WS) end. Cobble grouted spillway. Cobble grouted intake on the landside (LS). (Intake end plugged, and pipe filled with concrete under Permit No. 17426, 2003 - Western Dairy Design Associates, Inc.). [Additional Reference(s): DWR Levee Log, 1978. USACE San Joaquin O&M Manual 612.2, 1967, (HLM 3.04)]. FS Date: 6/11/2014

Headwall, flapgate, and grouted spillway on WS slope.

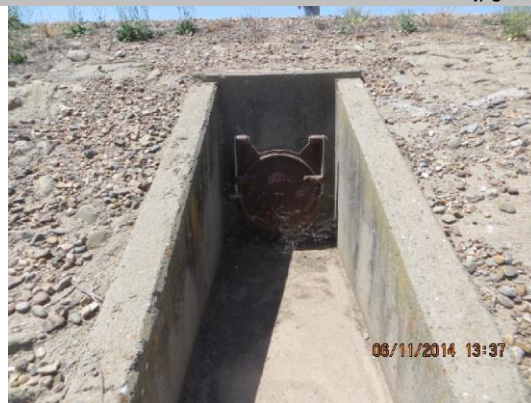
Photo 2 of 3 : UCIP_FA_2017_38539_70545.jpg

FS_ID:38539
DS_ID:23892
EP_NO: N/A
Repair Type: Non-Urgent
Crossing Status: Found
UCIP Comments: Pipe abandoned and if so should be done so properly. Verify if possible pipe filled with concrete.
FIELD_STRUCT_DESC: *ABANDONED* 24-inch corrugated metal drainage pipe through the levee, 6.5 feet below the crown. Concrete U-shaped headwall on both ends. Flap gate on the waterside (WS) end. Cobble grouted spillway. Cobble grouted intake on the landside (LS). (Intake end plugged, and pipe filled with concrete under Permit No. 17426, 2003 - Western Dairy Design Associates, Inc.). [Additional Reference(s): DWR Levee Log, 1978. USACE San Joaquin O&M Manual 612.2, 1967, (HLM 3.04)].
FS Date: 6/11/2014

Headwall and flapgate on WS slope.

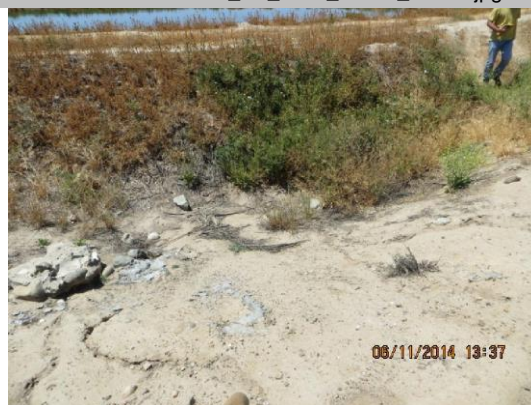
Photo 3 of 3 : UCIP_FA_2017_38539_70544.jpg

LS filled in with concrete per notes.

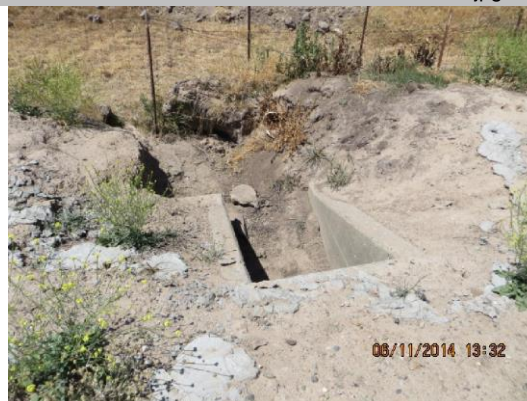
Photo 1 of 3 : UCIP_FA_2017_38538_70541.jpg

Headwall at LS toe.

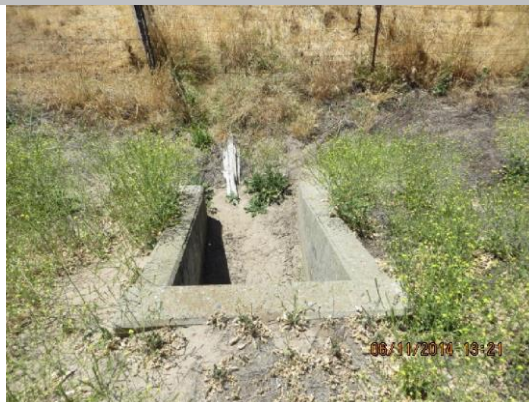
Photo 2 of 3 : UCIP_FA_2017_38536_70533.jpg

Headwall at LS toe.

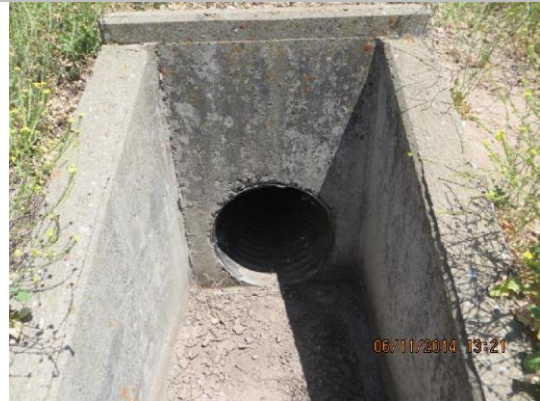
Photo 3 of 3 : UCIP_FA_2017_38536_70532.jpg

Headwall at LS toe.

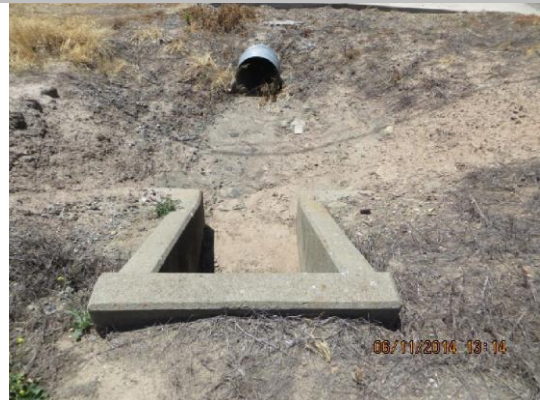
Photo 1 of 3 : UCIP_FA_2017_38535_70529.jpg

Headwall at LS toe.

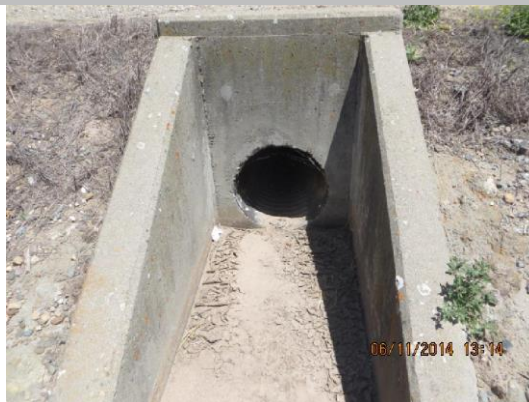
Photo 3 of 3 : UCIP_FA_2017_38535_70527.jpg

Headwall at LS toe.

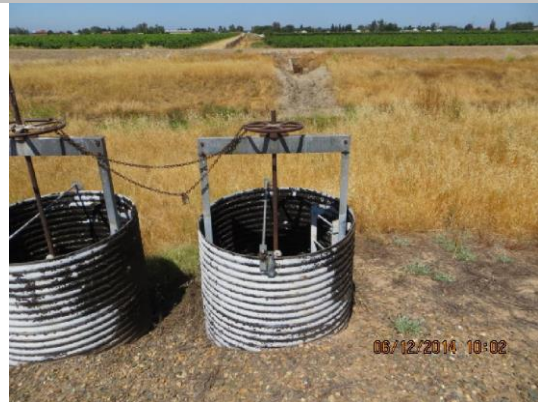
Photo 1 of 3 : UCIP_FA_2017_40788_70672.jpg

LM Start	0.14	Rating **	M	Issue No.	114
LM End	0.14	Issue Type +	Ma	Location *	
Category	Supplemental			GPS Latitude/Longitude	
				Start	End
Item	DWR UCIP LMA Responsibility			38.097104 °	38.097104 °
				-121.168757 °	-121.168757 °
DWR ID					
Comment Code					
Inspector Comment					
FS_ID:40788 DS_ID:23925 EP_NO: N/A Repair Type: Non-Urgent Crossing Status: Found UCIP Comments: Gate valve rusted in place. No lid or cover on Standpipe on WS slope. FIELD_STRUCT_DESC: 1 of 2: 42-inch corrugated metal drainage pipe through the levee, 7 feet below the crown. Slide gate in a 56-inch corrugated metal riser unit on the waterside (WS) slope. Flap gate on the WS end. Concrete headwall on both ends. [Additional Reference(s): DWR Levee Log, 1978. USACE San Joaquin O&M Manual 612.2, 1967, (HLM 0.14) 36-inch pipe listed]. FS Date: 6/12/2014

Slidegate in CMP riser on WS slope. No lid and gate rusted in place.

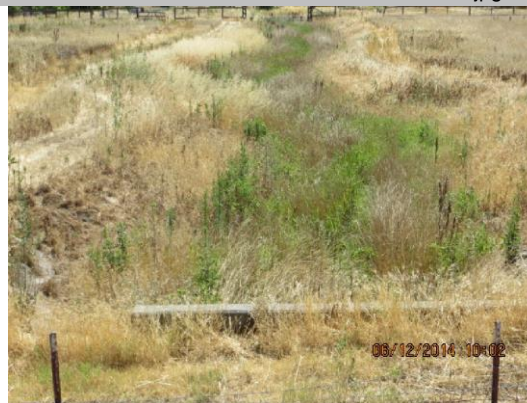
Photo 2 of 3 : UCIP_FA_2017_40788_70671.jpg

Headwall on LS toe.

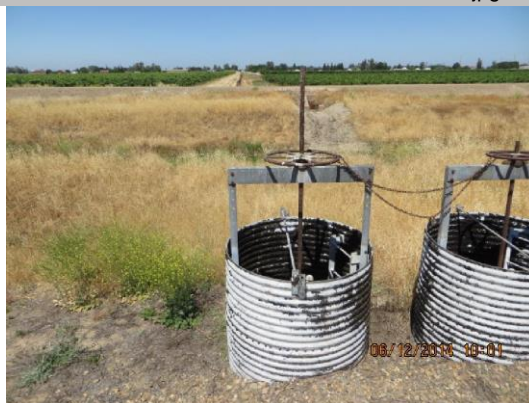
Photo 1 of 3 : UCIP_FA_2017_38569_70669.jpg

LM Start	0.15	Rating **	M	Issue No.	115	
LM End	0.15	Issue Type +	Ma	Location *		
Category	Supplemental			GPS Latitude/Longitude		
				Start	End	
Item	DWR UCIP LMA Responsibility			38.097126 °	38.097126 °	
				-121.168760 °	-121.168760 °	
DWR ID						
Comment Code						
Inspector Comment						
FS_ID:38569						
DS_ID:23930						
EP_NO: N/A						
Repair Type: Non-Urgent						
Crossing Status: Found						
UCIP Comments: No lid on riser and slide gate actuator rusted in place.						
FIELD_STRUCT_DESC: 2 of 2: 42-inch corrugated metal drainage pipe						
through the levee, 7 feet below the crown. Slide gate in 56-inch						
corrugated metal riser unit on the waterside (WS) slope. Flap gate on						
the WS end. [Additional Reference(s): DWR Levee Log, 1978. USACE						
San Joaquin O&M Manual 612.2, 1967, (HLM 0.14) 36-inch pipe listed].						
FS Date: 6/12/2014

Slide gate in CMP riser on WS slope. No lid on riser and gate rusted in place.

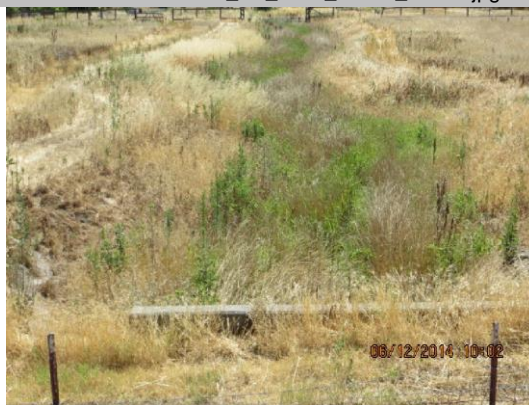
Photo 2 of 3 : UCIP_FA_2017_38569_70668.jpg

Headwall at LS toe not accessible

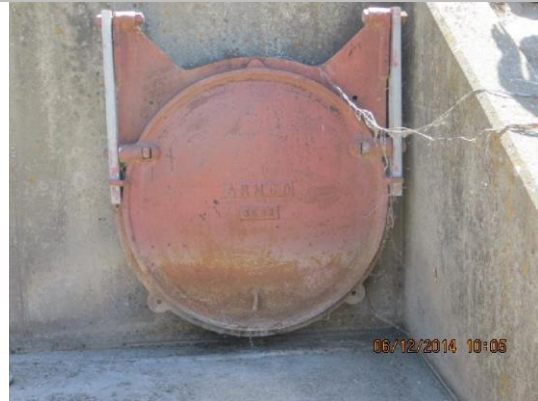
Photo 3 of 3 : UCIP_FA_2017_38569_70667.jpg

Headwall and flapgate on WS slope.

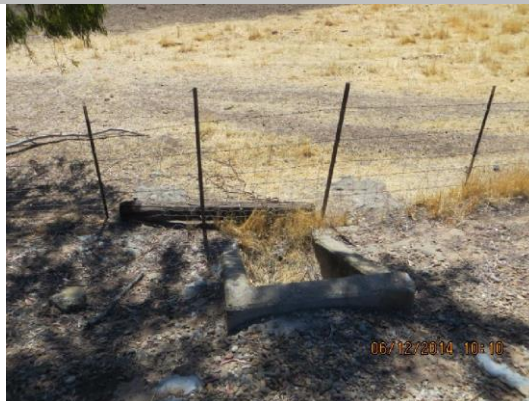
Photo 2 of 3 : UCIP_FA_2017_38573_70674.jpg

Headwall at LS toe.

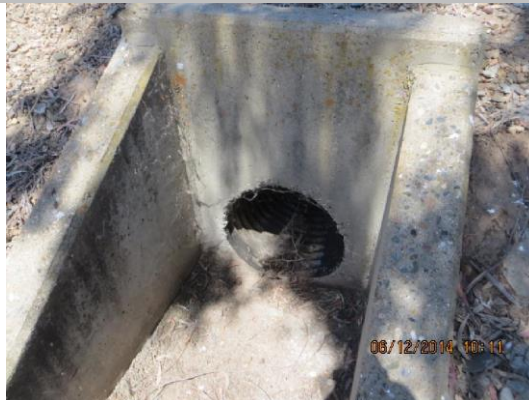
Photo 3 of 3 : UCIP_FA_2017_38573_70673.jpg

Headwall at LS toe.

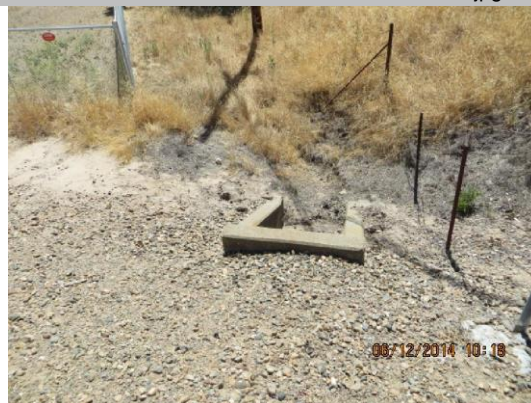
Photo 1 of 3 : UCIP_FA_2017_38574_70680.jpg

Headwall at LS toe.

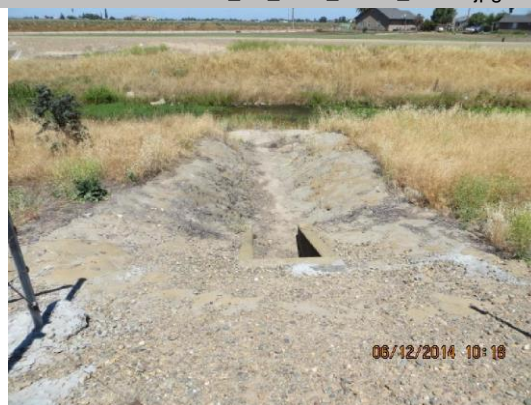
Photo 2 of 3 : UCIP_FA_2017_38574_70679.jpg

Headwall, flapgate, and grouted spillway on WS slope.

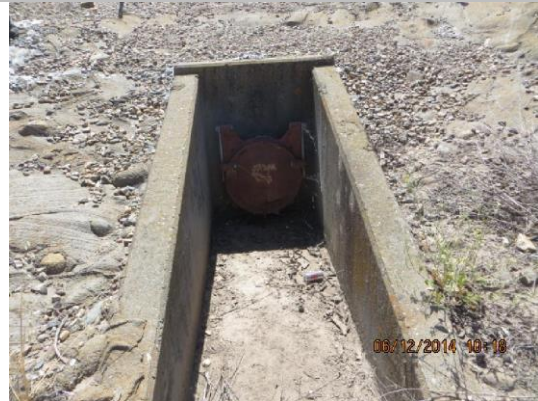
Photo 3 of 3 : UCIP_FA_2017_38574_70678.jpg

Headwall and flapgate on WS slope.

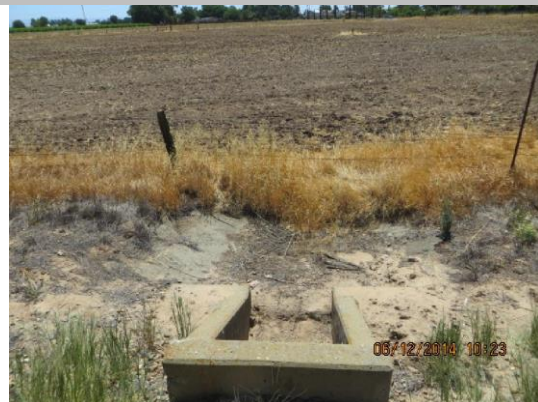
Photo 1 of 3 : UCIP_FA_2017_38576_70690.jpg

Headwall at LS toe.

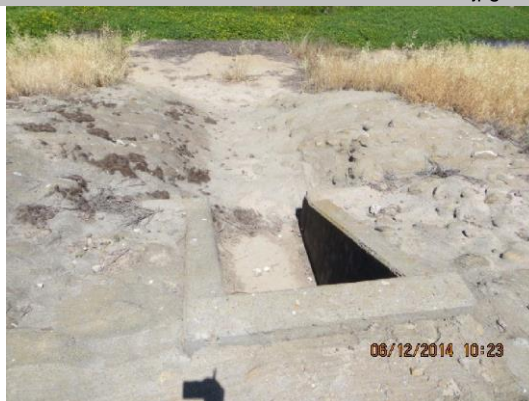
Photo 2 of 3 : UCIP_FA_2017_38576_70689.jpg

Headwall, flapgate, and grouted spillway on WS slope.

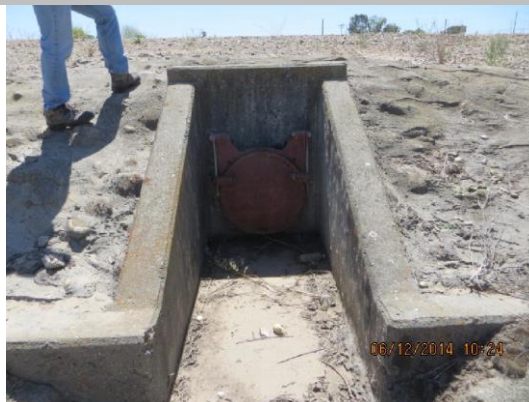
Photo 3 of 3 : UCIP_FA_2017_38576_70688.jpg

Headwall and flapgate on WS slope.

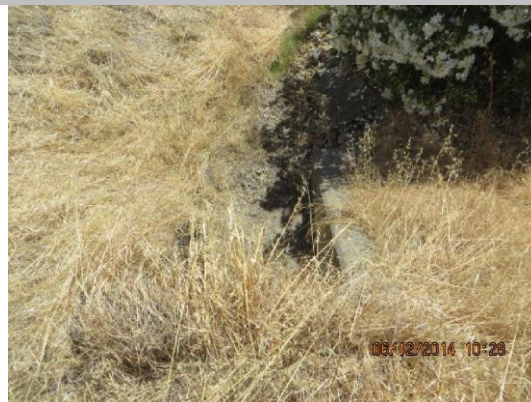
Photo 2 of 3 : UCIP_FA_2017_38577_70694.jpg

Headwall at LS toe.

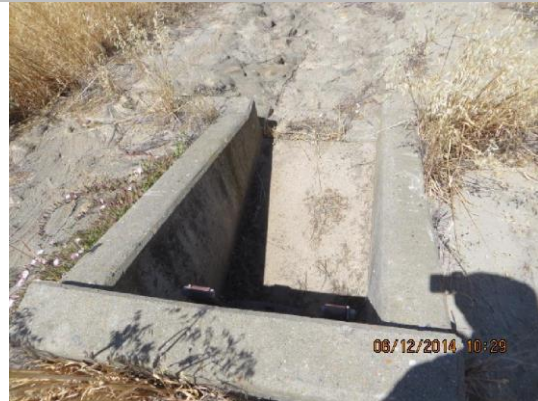
Photo 3 of 3 : UCIP_FA_2017_38577_70693.jpg

Headwall, flapgate, and grouted spillway on WS slope.

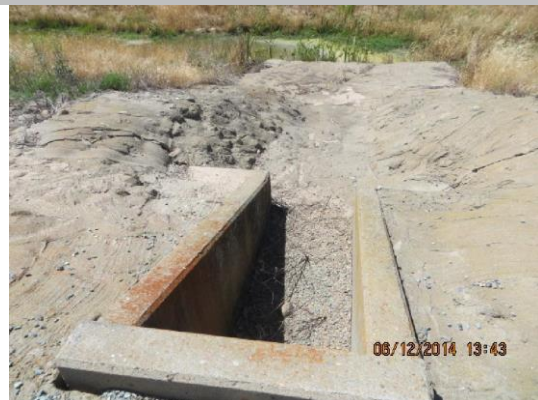
Photo 1 of 3 : UCIP_FA_2017_38624_70787.jpg

Headwall, flapgate, and grouted spillway on WS slope.

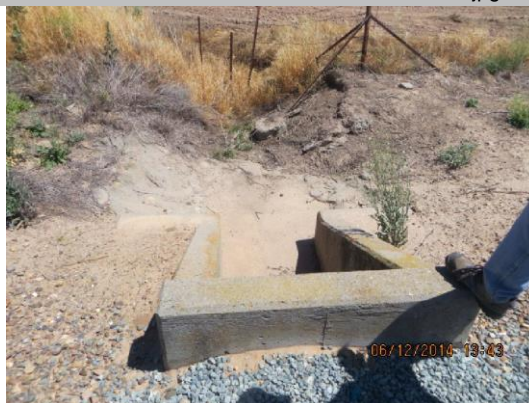
Photo 2 of 3 : UCIP_FA_2017_38624_70786.jpg

Headwall at LS toe.

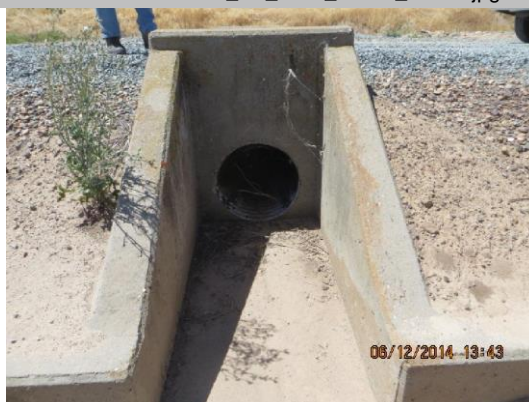
Photo 3 of 3 : UCIP_FA_2017_38624_70785.jpg

Headwall at LS toe.

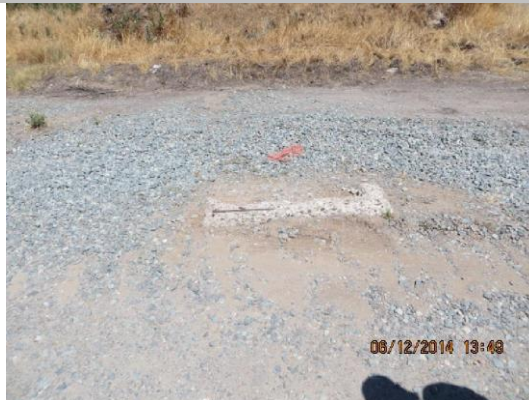
Photo 2 of 3 : UCIP_FA_2017_38626_70794.jpg

FS_ID:38626
DS_ID:23905
EP_NO: N/A
Repair Type: Non-Urgent
Crossing Status: Found
UCIP Comments: Pipe is covered with soil at inlet on LS.
FIELD_STRUCT_DESC: 24-inch corrugated metal drainage pipe through the levee, 3.5 feet below the crown. Concrete U-shaped headwalls on both ends. Flap gate on the waterside (WS) end. Cobble grouted spillway. Cobble grouted intake on the landside (LS).
[Additional Reference(s): DWR Levee Log, 1978. USACE San Joaquin O&M Manual 612.2, 1967, (HLM 1.90)].
FS Date: 6/12/2014

Headwall at LS toe buried in soil.

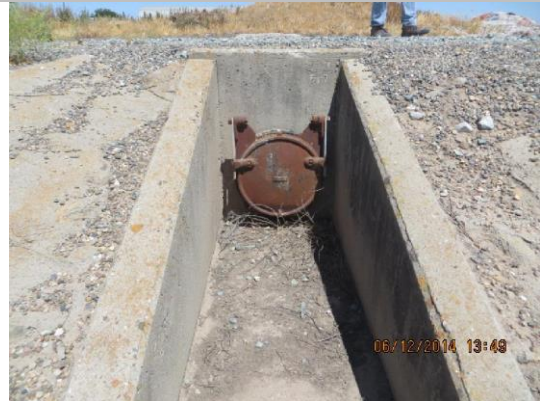
Photo 3 of 3 : UCIP_FA_2017_38626_70793.jpg

Headwall and flapgate on WS slope.

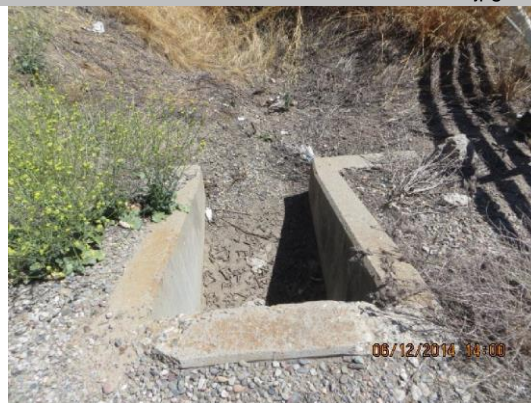
Photo 2 of 3 : UCIP_FA_2017_38629_70804.jpg

Headwall at LS toe.

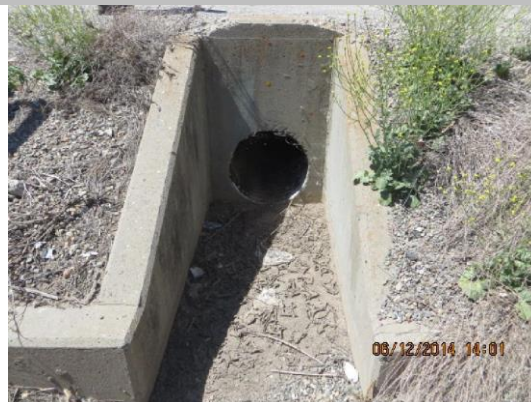
Photo 3 of 3 : UCIP_FA_2017_38629_70803.jpg

Headwall at LS toe.

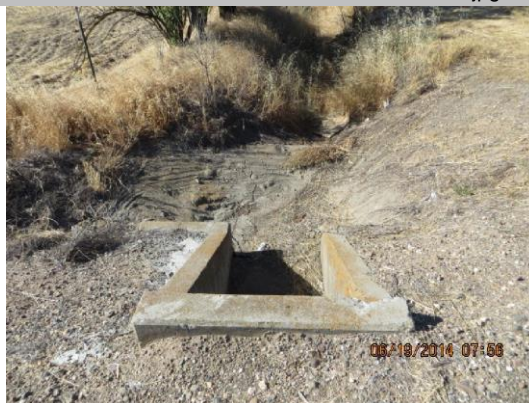
Photo 1 of 3 : UCIP_FA_2017_38630_70810.jpg

Headwall at LS toe.

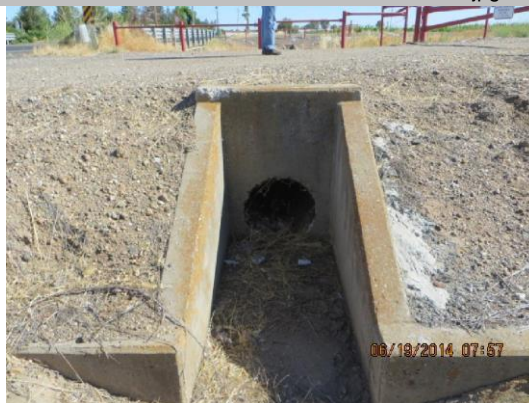
Photo 3 of 3 : UCIP_FA_2017_38630_70808.jpg

Headwall at LS toe.

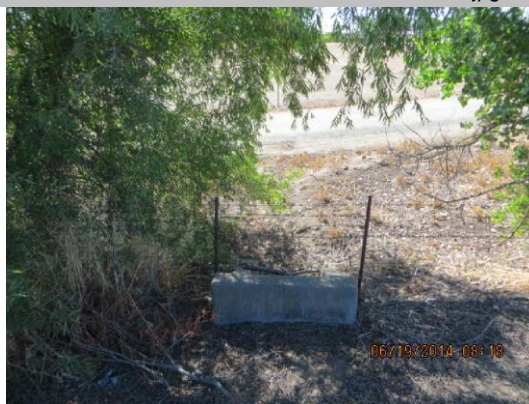
Photo 1 of 3 : UCIP_FA_2017_38632_70815.jpg

LM Start	2.36	Rating **	A/W	Issue No.	128
LM End	2.36	Issue Type +	Ma	Location *	
Category	Supplemental			GPS Latitude/Longitude	
				Start	End
Item	DWR UCIP LMA Responsibility			38.118995 °	38.118995 °
				-121.147840 °	-121.147840 °
DWR ID					
Comment Code					
Inspector Comment					
FS_ID:38632 DS_ID:23911 EP_NO: N/A Repair Type: No Action Needed Crossing Status: Found UCIP Comments: FIELD_STRUCT_DESC: 24-inch corrugated metal drainage pipe through the levee, 6 feet below the crown. Concrete U-shaped headwalls on both ends. Flap gate on the waterside (WS) end. Cobble grouted spillway. Cobble grouted intake on the landside (LS). [Additional Reference(s): DWR Levee Log, 1978. USACE San Joaquin O&M Manual 612.2, 1967, (HLM 2.36)]. FS Date: 6/19/2014

Headwall at LS toe.

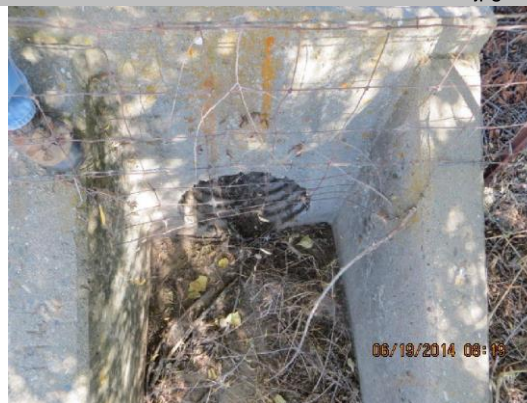
Photo 2 of 3 : UCIP_FA_2017_38632_70814.jpg

Headwall at LS toe.

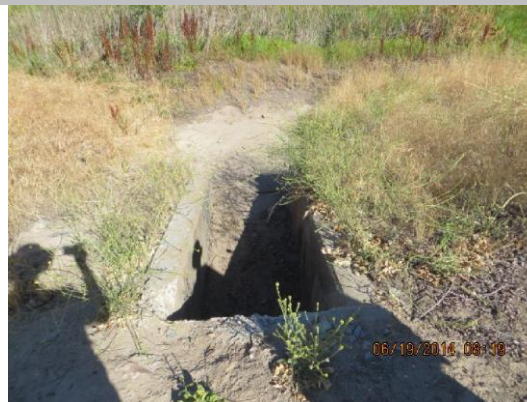
Photo 3 of 3 : UCIP_FA_2017_38632_70813.jpg

Headwall, flapgate, and grouted spillway on WS slope.

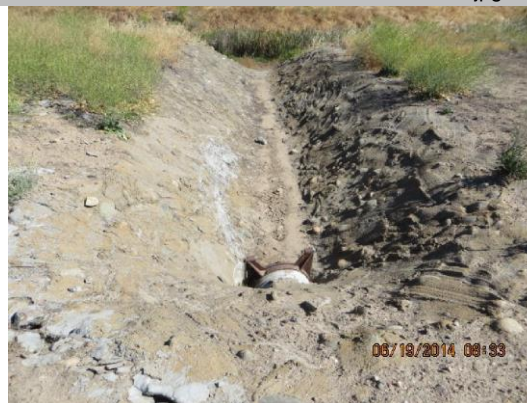
Photo 1 of 3 : UCIP_FA_2017_51630_70822.jpg

FS_ID:51630
DS_ID:23913
EP_NO: N/A
Repair Type: Non-Urgent
Crossing Status: Found
UCIP Comments: 11/04/2016 Crossing has been downgraded from Urgent to Non-Urgent the silt buildup in front of the flapgate on the WS has been removed, however the sediment buildup inside the crossing still remains. Recommend clearing the sediment buildup inside the pipe and complete an internal integrity inspection to confirm crossing is in good condition. (O. Magana - DWR UCIP) 06/19/2014 Silt buildup on WS toe blocking flapgate operation. (W. Wylie - DWR UCIP)
FIELD_STRUCT_DESC: 24-inch corrugated metal drainage pipe through the levee, 4 feet below the crown. Flap gate is located on the waterside (WS) end with a cobble grouted spillway. Cobble grouted intake on the landside (LS). [Additional Reference(s): DWR Levee Log, 1977, 1978, 1987, 1990. USACE San Joaquin O&M Manual Unit 612, Part No. 2 - Bear Creel Project, Unit 7: HLM 7.19 – 16.77, Unit 8: HLM 7.55-16.48, Unit 9: HLM 0.10-1.52; Unit 10: HLM 0.03-1.35, Unit 11: HLM 0.16-3.55, Unit 12: HLM 0.14-3.91; Unit 13, HLM 0.03-1.18; Unit 14, HLM 0.02-1.17, 1967, (HLM 2.61)]

Flapgate and grouted spillway on WS slope.

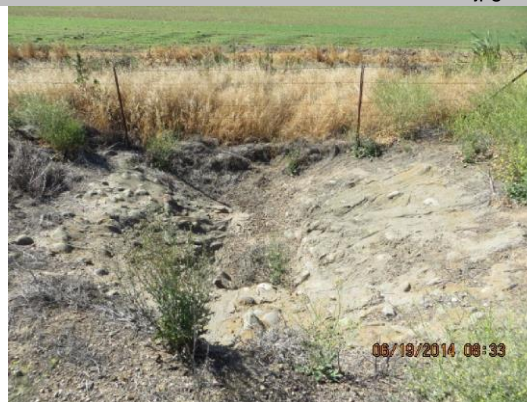
Photo 2 of 3 : UCIP_FA_2017_51630_70821.jpg

Inlet at LS toe.
