**Flood Control Project Maintenance
Levee Inspections**

Maintenance Issue Types Only, Levee Inspection Report By Mile - Fall 2017

San Joaquin County Flood Control and Water Conservation District

Waterway	Bank	Unit Miles	Inspection Start/End	Inspector
Unit No. 01 Littlejohn Creek	Left	2.59	10/17/2017 10/17/2017	Pavel Kazi

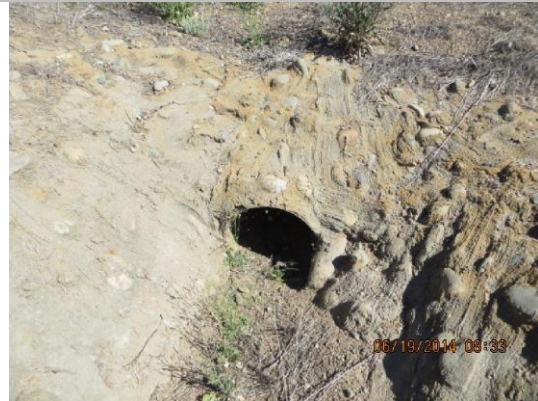
Photo 3 of 3 : UCIP_FA_2017_51630_70820.jpg

Comment Code						
Inspector Comment						
FS_ID:51630 DS_ID:23913 EP_NO: N/A Repair Type: Non-Urgent Crossing Status: Found UCIP Comments: 11/04/2016 Crossing has been downgraded from Urgent to Non-Urgent the silt buildup in front of the flapgate on the WS has been removed, however the sediment buildup inside the crossing still remains. Recommend clearing the sediment buildup inside the pipe and complete an internal integrity inspection to confirm crossing is in good condition. (O. Magana - DWR UCIP) 06/19/2014 Silt buildup on WS toe blocking flapgate operation. (W. Wylie - DWR UCIP) FIELD_STRUCT_DESC: 24-inch corrugated metal drainage pipe through the levee, 4 feet below the crown. Flap gate is located on the waterside (WS) end with a cobble grouted spillway. Cobble grouted intake on the landside (LS). [Additional Reference(s): DWR Levee Log, 1977, 1978, 1987, 1990. USACE San Joaquin O&M Manual Unit 612, Part No. 2 - Bear Creel Project, Unit 7: HLM 7.19 – 16.77, Unit 8: HLM 7.55-16.48, Unit 9: HLM 0.10-1.52; Unit 10: HLM 0.03-1.35, Unit 11: HLM 0.16-3.55, Unit 12: HLM 0.14-3.91; Unit 13, HLM 0.03-1.18; Unit 14, HLM 0.02-1.17, 1967, (HLM 2.61)] FS Date: 11/4/2016 8:33:00 AM

Inlet at LS toe.

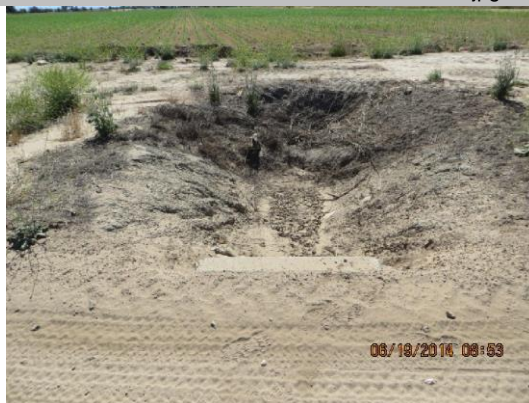
Photo 1 of 3 : UCIP_FA_2017_38636_70832.jpg

LM Start	2.72	Rating **	A/W	Issue No.	133
LM End	2.72	Issue Type +	Ma	Location *	
Category	Supplemental			GPS Latitude/Longitude	
				Start	End
Item	DWR UCIP LMA Responsibility			38.122733 °	38.122733 °
				-121.144351 °	-121.144351 °
DWR ID					
Comment Code					
Inspector Comment					
FS_ID:38636					
DS_ID:23915					
EP_NO: N/A					
Repair Type: No Action Needed					
Crossing Status: Found					
UCIP Comments:					
FIELD_STRUCT_DESC: 12-inch corrugated metal drainage pipe					
through the levee, 2 feet below the crown. Flap gate on the waterside					
(WS) end. Cobble grouted spillway. Cobble grouted intake on the					
landside (LS). [Additional Reference(s): DWR Levee Log, 1978. USACE					
San Joaquin O&M Manual 612.2, 1967, (HLM 2.72)].					
FS Date: 6/19/2014

Headwall and pipe at LS shoulder.

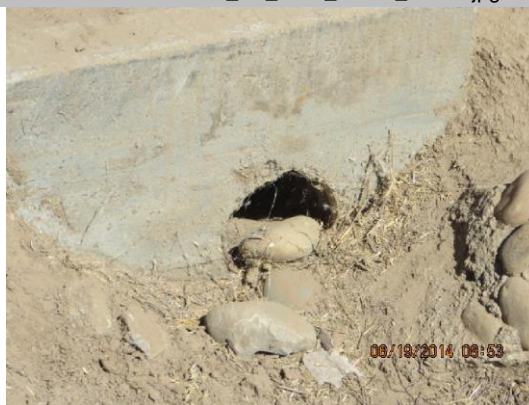
Photo 2 of 3 : UCIP_FA_2017_38636_70831.jpg

Headwall and pipe at LS shoulder.

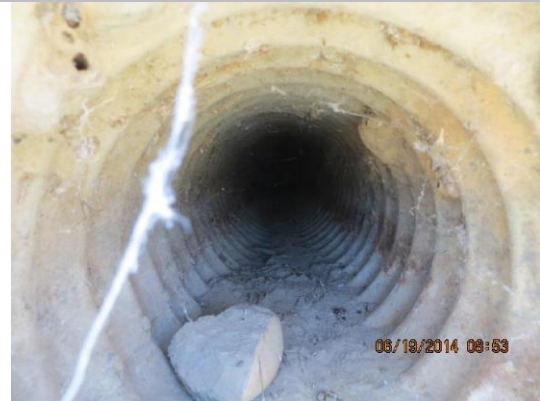
Photo 3 of 3 : UCIP_FA_2017_38636_70830.jpg

Inside pipe on LS shoulder.

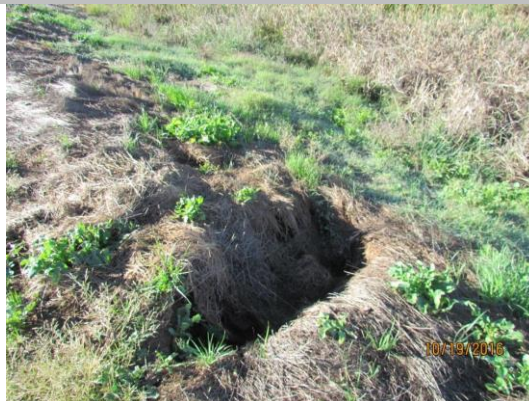
Photo 1 of 1 : FA_2017_NA0017_156_29_20170921_00012.jpg

LM Start	2.92	Rating **	M	Issue No.	29
LM End	2.92	Issue Type +	Ma	Location *	WS
Category	Earthen Levee			GPS Latitude/Longitude	
				Start	End
Item	Erosion / Bank Caving			38.125654 °	38.125654 °
				-121.143946 °	-121.143946 °
DWR ID	DWR_NA0017_12_f_2016_29				
Comment Code					
E2 : Schedule repair of erosion site prior to the next inspection.					
Inspector Comment

View of an erosion on the waterside shoulder of the levee. Fall 2016.

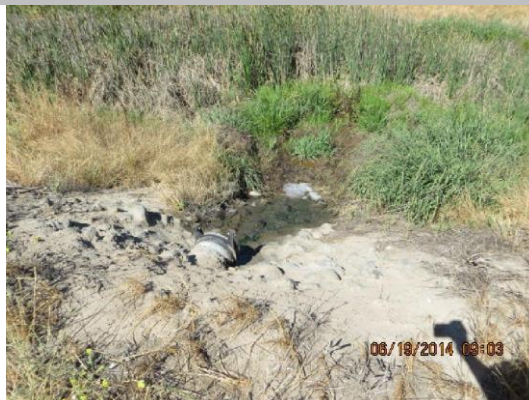
Photo 1 of 3 : UCIP_FA_2017_38638_70838.jpg

LM Start	2.94	Rating **	A/W	Issue No.	134
LM End	2.94	Issue Type +	Ma	Location *	
Category	Supplemental			GPS Latitude/Longitude	
				Start	End
Item	DWR UCIP LMA Responsibility			38.125894 °	38.125894 °
				-121.143970 °	-121.143970 °
DWR ID					
Comment Code					
Inspector Comment					
FS_ID:38638 DS_ID:23916 EP_NO: N/A Repair Type: No Action Needed Crossing Status: Found UCIP Comments: FIELD_STRUCT_DESC: 12-inch corrugated metal drainage pipe through the levee, 3 feet below the crown. Flap gate on the waterside (WS) end. Cobble grouted spillway. (Positive closure device installed on intake end under Permit No. 17426, 2003 - Western Dairy Design Associates, Inc.). [Additional Reference(s): DWR Levee Log, 1978. USACE San Joaquin O&M Manual 612.2, 1967, (HLM 2.95)]. FS Date: 6/19/2014

Flapgate on CMP pipe at WS slope with grouted spillway.

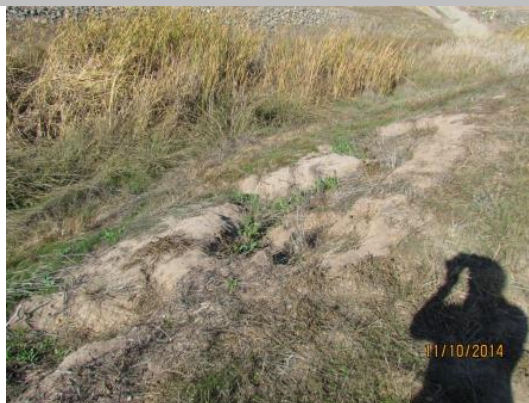
Photo 1 of 1 : FA_2017_NA0017_156_32_20170921_00015.jpg

LM Start	2.97	Rating **	M	Issue No.	32
LM End	2.97	Issue Type +	Ma	Location *	WS
Category	Earthen Levee			GPS Latitude/Longitude	
				Start	End
Item	Slope Stability			38.126304 °	38.126304 °
				-121.143996 °	-121.143996 °
DWR ID	DWR_NA0017_12_f_2014_32				
Comment Code					
S1 : Repair slope instability.					
Inspector Comment

View of a slope instability that was found on the waterside of the levee looking upstream.

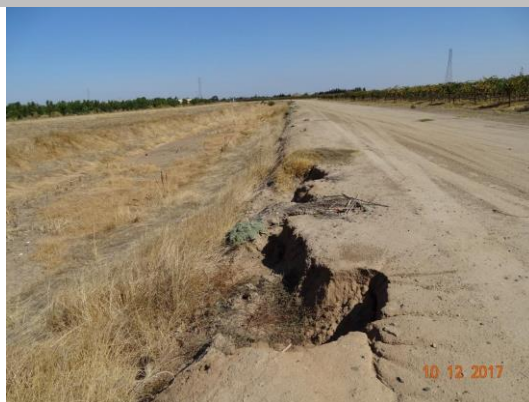
Photo 1 of 1 : FA_2017_NA0017_156_43_20171016_00143.jpg

LM Start	3.10	Rating **	M	Issue No.	43
LM End	3.10	Issue Type +	Ma	Location *	WS
Category	Earthen Levee			GPS Latitude/Longitude	
				Start	End
Item	Erosion / Bank Caving			38.127044 °	38.127044 °
				-121.141744 °	-121.141744 °
DWR ID	DWR_NA0017_12_f_2017_43				
Comment Code					
E2 : Schedule repair of erosion site prior to the next inspection.					
Inspector Comment

View of erosions on the waterside shoulder of the levee looking upstream. Fall 2017

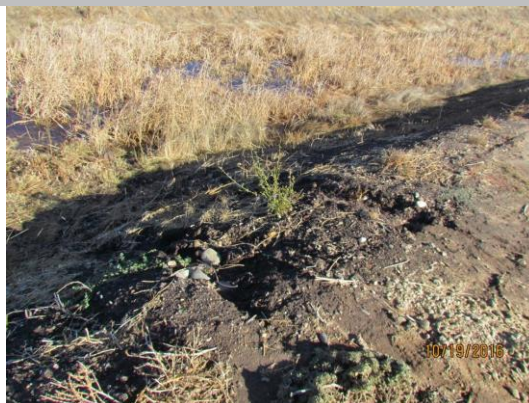
Photo 1 of 2 : FA_2017_NA0017_156_31_20170921_00013.jpg

LM Start	3.14	Rating **	M	Issue No.	31
LM End	3.14	Issue Type +	Ma	Location *	WS
Category	Earthen Levee			GPS Latitude/Longitude	
				Start	End
Item	Erosion / Bank Caving			38.127390 °	38.127390 °
				-121.141197 °	-121.141197 °
DWR ID	DWR_NA0017_12_s_2016_31				
Comment Code					
E2 : Schedule repair of erosion site prior to the next inspection.					
Inspector Comment

Updated picture of the erosion on the waterside shoulder of the levee.
Fall 2016

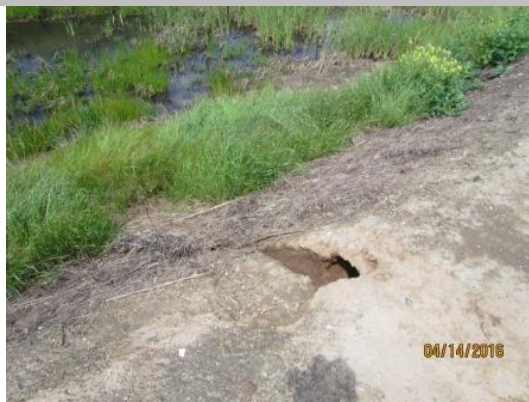
Photo 2 of 2 : FA_2017_NA0017_156_31_20170921_00014.jpg

View of an erosion on the waterside shoulder of the levee.

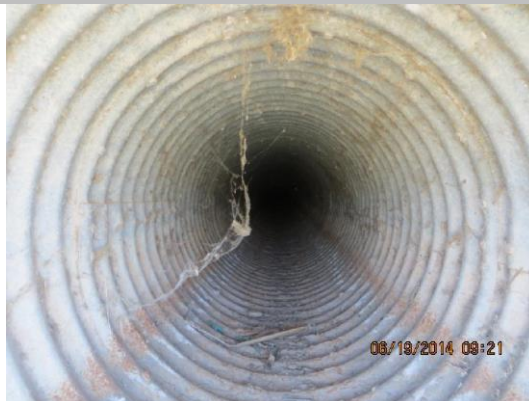
Photo 1 of 3 : UCIP_FA_2017_38643_70857.jpg

LM Start	3.23	Rating **	A/W	Issue No.	137
LM End	3.23	Issue Type +	Ma	Location *	
Category	Supplemental			GPS Latitude/Longitude	
				Start	End
Item	DWR UCIP LMA Responsibility			38.128162 °	38.128162 °
				-121.139922 °	-121.139922 °
DWR ID					
Comment Code					
Inspector Comment					
FS_ID:38643					
DS_ID:23917					
EP_NO: N/A					
Repair Type: No Action Needed					
Crossing Status: Found					
UCIP Comments: No flapgate					
FIELD_STRUCT_DESC: 24-inch corrugated metal drainage pipe					
through the levee, 4.5 feet below the crown. Cobble grouted spillway.					
Cobble grouted intake on the landside (LS). [Additional Reference(s):					
DWR Levee Log, 1978. USACE San Joaquin O&M Manual 612.2, 1967,					
(HLM 3.25)].					
FS Date: 6/19/2014

Inside pipe at WS slope.

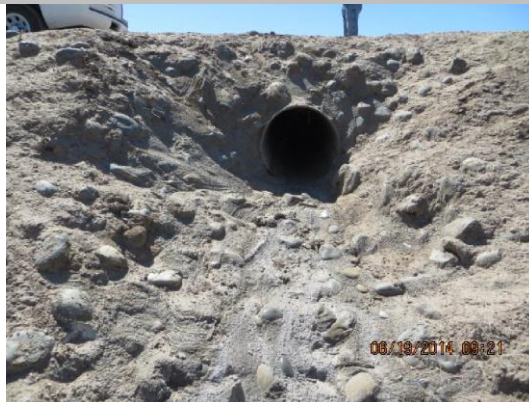
Photo 2 of 3 : UCIP_FA_2017_38643_70856.jpg

Pipe and grouted spillway on WS slope.

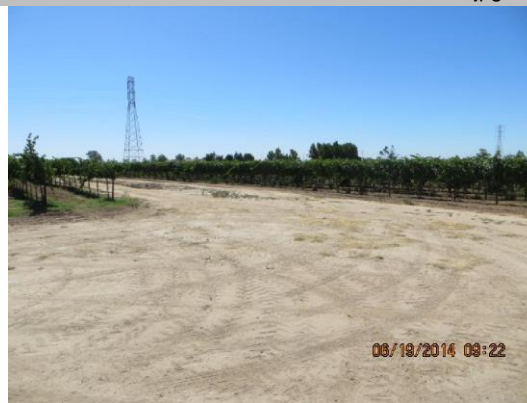
Photo 3 of 3 : UCIP_FA_2017_38643_70855.jpg

Ditch for inlet well off LS shoulder.

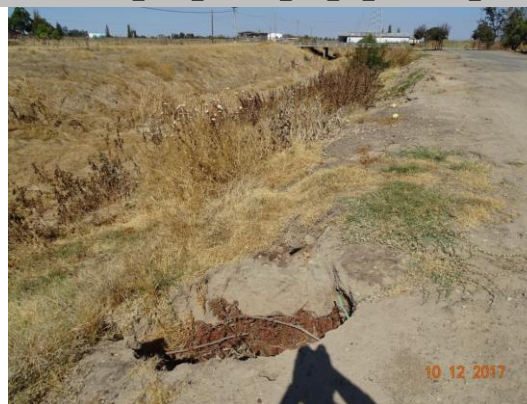
Photo 1 of 1 : FA_2017_NA0017_156_44_20171016_00144.jpg

LM Start	3.45	Rating **	M	Issue No.	44
LM End	3.45	Issue Type +	Ma	Location *	WS
Category	Earthen Levee			GPS Latitude/Longitude	
				Start	End
Item	Erosion / Bank Caving			38.130982 °	38.130982 °
				-121.138597 °	-121.138597 °
DWR ID	DWR_NA0017_12_f_2017_44				
Comment Code					
E2 : Schedule repair of erosion site prior to the next inspection.					
Inspector Comment

View of the erosion on the waterside shoulder of the levee. Fall 2017

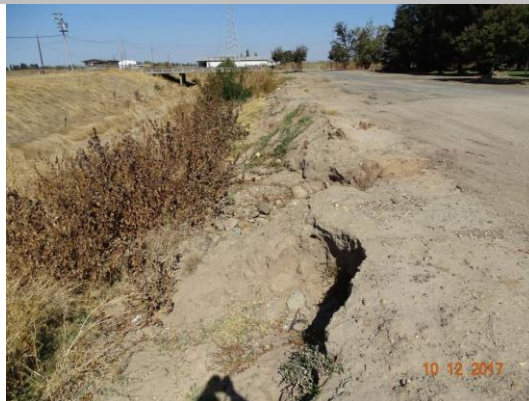
Photo 1 of 2 : FA_2017_NA0017_156_24_20171016_00145.jpg

LM Start	3.46	Rating **	M	Issue No.	24
LM End	3.46	Issue Type +	Ma	Location *	WS
Category	Earthen Levee			GPS Latitude/Longitude	
				Start	End
Item	Erosion / Bank Caving			38.131140 °	38.131140 °
				-121.138541 °	-121.138541 °
DWR ID	DWR_NA0017_12_f_2012_24				
Comment Code					
E2 : Schedule repair of erosion site prior to the next inspection.					
Inspector Comment

Updated picture of the erosion on the waterside of the levee. Fall 2017

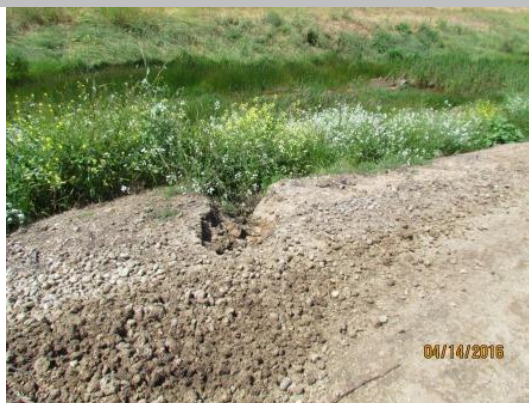
Photo 2 of 2 : FA_2017_NA0017_156_24_20170921_00009.jpg

View of the erosion on the waterside of the levee during spring 2016 inspection.

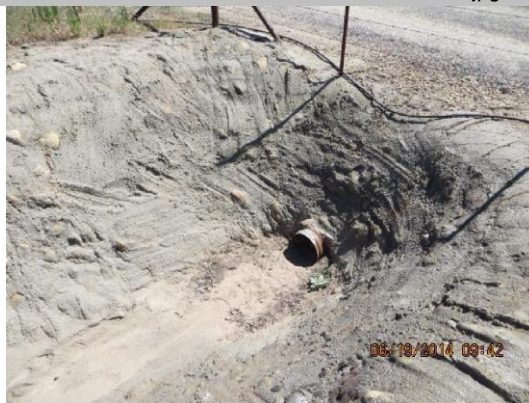
Photo 1 of 3 : UCIP_FA_2017_38646_70866.jpg

LM Start	3.51	Rating **	A/W	Issue No.	139
LM End	3.51	Issue Type +	Ma	Location *	
Category	Supplemental			GPS Latitude/Longitude	
				Start	End
Item	DWR UCIP LMA Responsibility			38.131725 °	38.131725 °
				-121.138422 °	-121.138422 °
DWR ID					
Comment Code					
Inspector Comment					
FS_ID:38646					
DS_ID:23920					
EP_NO: N/A					
Repair Type: No Action Needed					
Crossing Status: Found					
UCIP Comments:					
FIELD_STRUCT_DESC: 12-inch corrugated metal drainage pipe					
through the levee, 4.5 feet below the crown. Cobble grouted spillway.					
[Additional Reference(s): DWR Levee Log, 1978. USACE San Joaquin					
O&M Manual 612.2, 1967, (HLM 3.52)].					
FS Date: 6/19/2014

Pipe on WS slope.

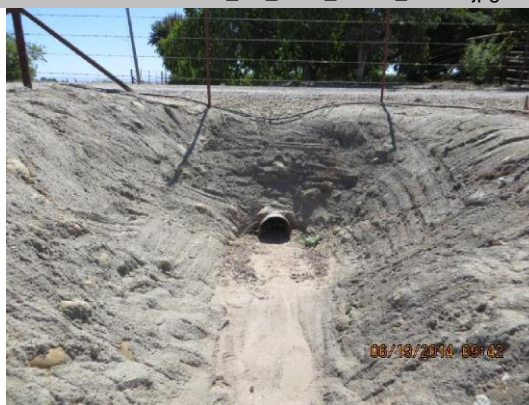
Photo 2 of 3 : UCIP_FA_2017_38646_70865.jpg

Pipe on WS slope.

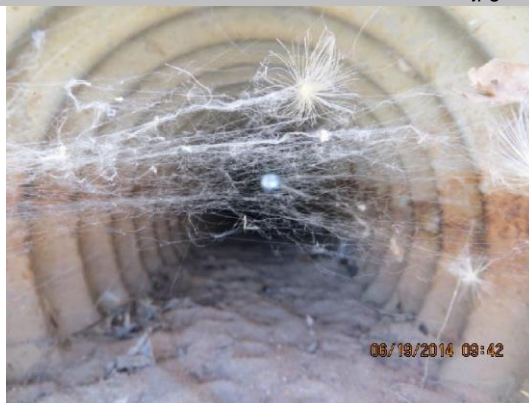
Photo 3 of 3 : UCIP_FA_2017_38646_70864.jpg

Inside pipe at WS toe.

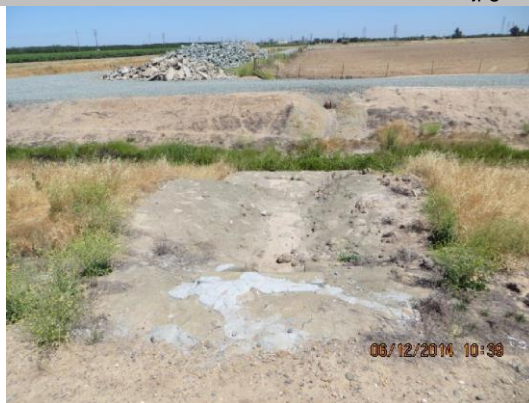
Photo 1 of 3 : UCIP_FA_2017_38578_70699.jpg

Headwall, flapgate, and grouted spillway on WS slope.

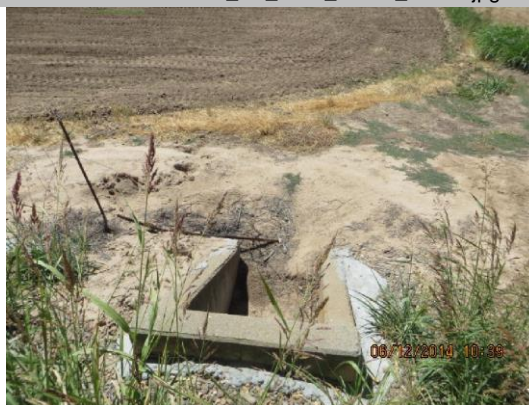
Photo 2 of 3 : UCIP_FA_2017_38578_70698.jpg

Headwall at LS toe.

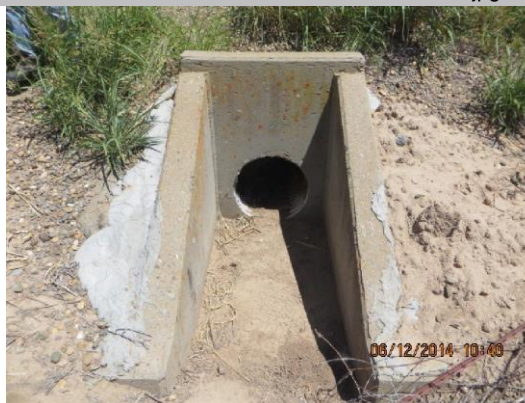
Photo 3 of 3 : UCIP_FA_2017_38578_70697.jpg

Headwall at LS toe.

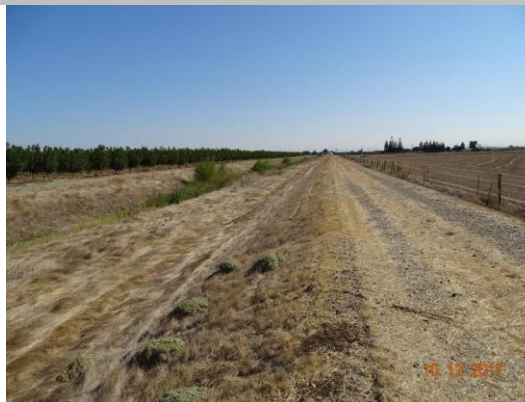
Photo 1 of 1 : FA_2017_NA0017_157_11_20171016_00044.jpg

LM Start	0.03	Rating **	A	Issue No.	11
LM End	0.03	Issue Type +	Ma	Location *	WS
Category	Earthen Levee			GPS Latitude/Longitude	
				Start	End
Item	Vegetation			38.109371 °	38.109371 °
				-121.159865 °	-121.159865 °
DWR ID	DWR_NA0017_13_f_2017_11				
Comment Code					
V1 : Control annual grass and weeds on the levee slopes and easements.					
Inspector Comment					
Acceptable vegetation.

View of the waterside slope of the levee. Fall 2017

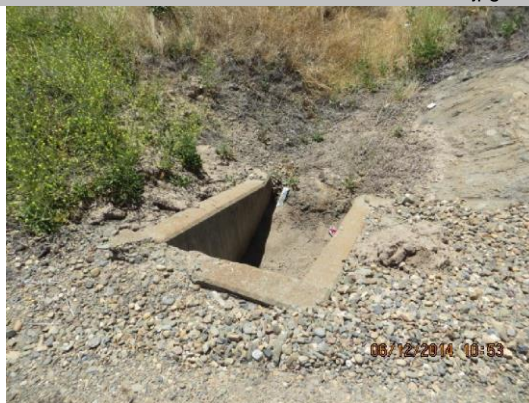
Photo 1 of 3 : UCIP_FA_2017_38581_70709.jpg

Headwall at LS toe.

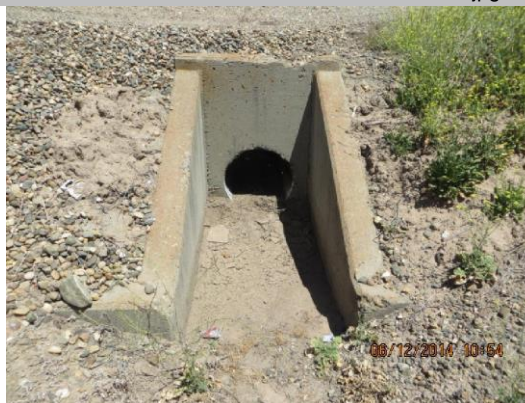
Photo 3 of 3 : UCIP_FA_2017_38581_70707.jpg

Headwall at LS toe.

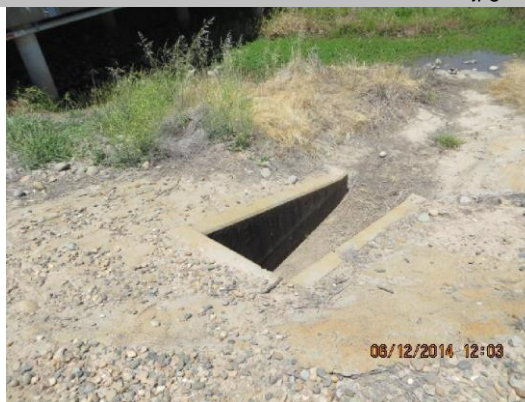
Photo 1 of 3 : UCIP_FA_2017_38582_70714.jpg

Headwall, flapgate, and grouted spillway on WS slope.

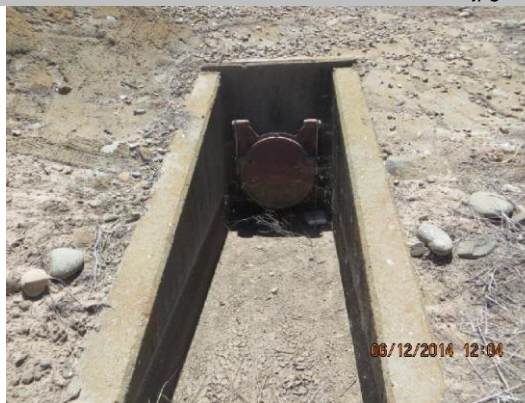
Photo 2 of 3 : UCIP_FA_2017_38582_70713.jpg

Headwall and flapgate on WS slope.

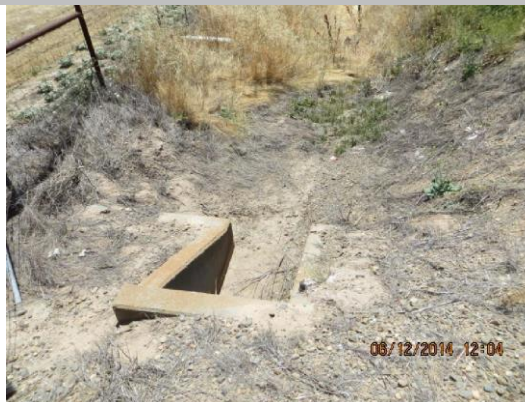
Photo 3 of 3 : UCIP_FA_2017_38582_70712.jpg

Headwall at LS toe.

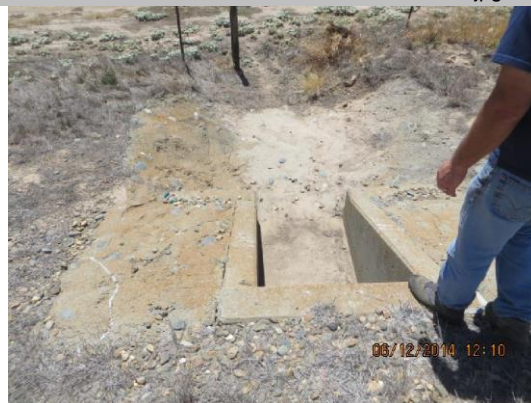
Photo 1 of 3 : UCIP_FA_2017_38583_70719.jpg

Headwall at LS toe.

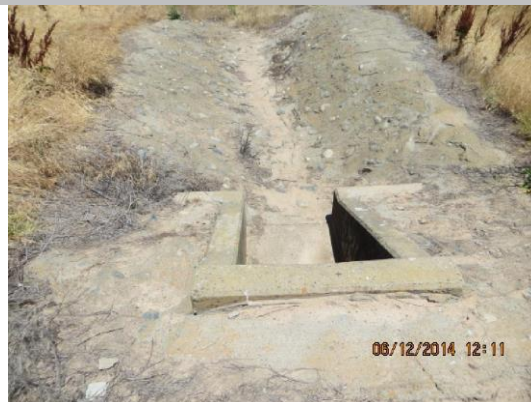
Photo 2 of 3 : UCIP_FA_2017_38583_70718.jpg

Headwall, flapgate, and grouted spillway on WS slope.

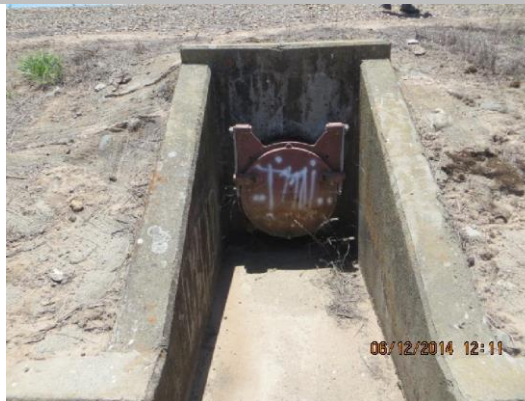
Photo 3 of 3 : UCIP_FA_2017_38583_70717.jpg

Headwall and flapgate on WS slope.

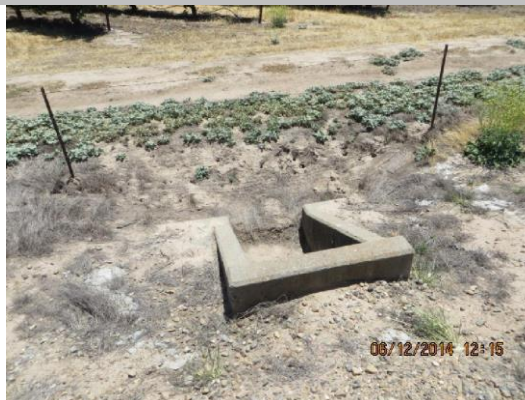
Photo 1 of 3 : UCIP_FA_2017_38585_70729.jpg

Headwall at LS toe.

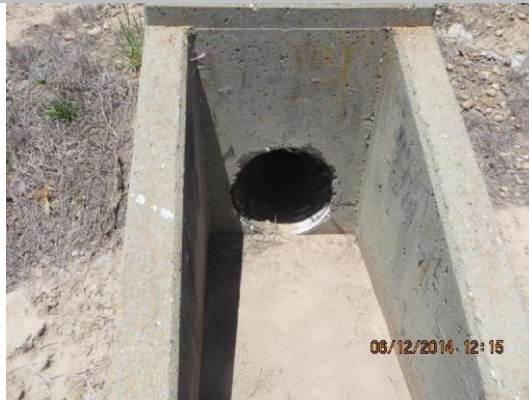
Photo 3 of 3 : UCIP_FA_2017_38585_70727.jpg

Headwall at LS toe.

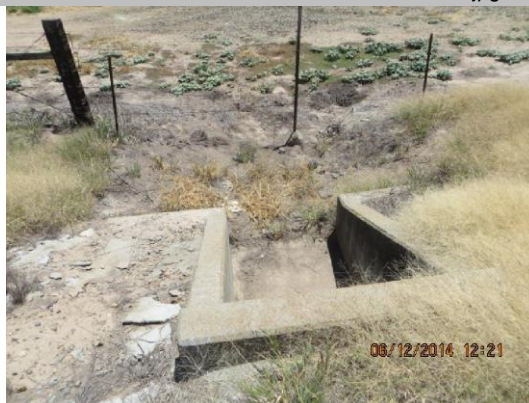
Photo 1 of 3 : UCIP_FA_2017_38586_70734.jpg

FS_ID:38586
DS_ID:23937
EP_NO: N/A
Repair Type: No Action Needed
Crossing Status: Found
UCIP Comments:
FIELD_STRUCT_DESC: 36-inch corrugated metal drainage pipe through the levee, 4 feet below the crown. Concrete U-shaped headwall on both ends. Flap gate on the waterside (WS) end. Cobble grouted spillway. Cobble grouted intake on the landside (LS). [Additional Reference(s): DWR Levee Log, 1978. USACE San Joaquin O&M Manual 612.2, 1967, (HLM 1.18)].
FS Date: 6/12/2014

Headwall at LS toe.

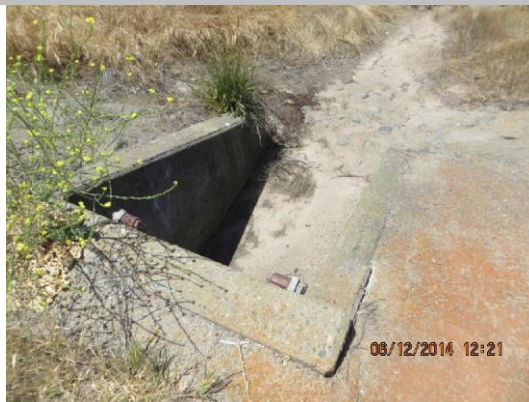
Photo 2 of 3 : UCIP_FA_2017_38586_70733.jpg

Headwall, flapgate, and grouted spillway on WS slope.

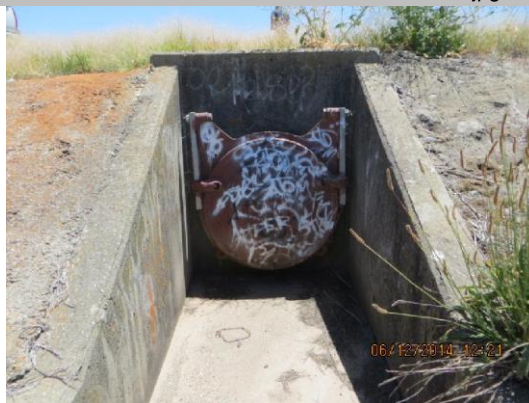
Photo 3 of 3 : UCIP_FA_2017_38586_70732.jpg

Headwall and flapgate on WS slope.

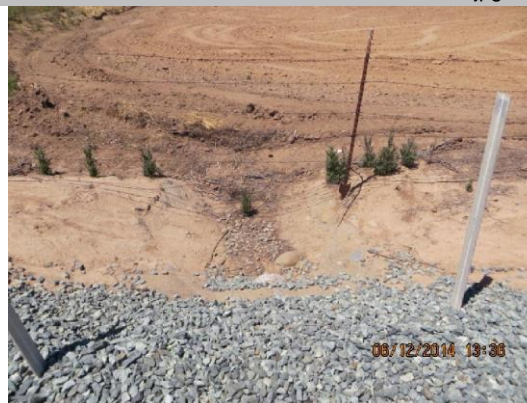
Photo 1 of 3 : UCIP_FA_2017_38623_70782.jpg

Pipe at inlet on LS shoulder.

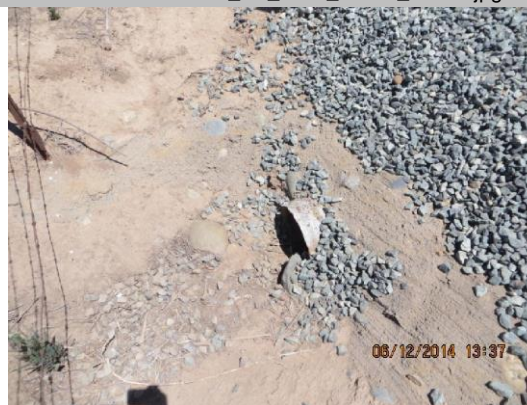
Photo 2 of 3 : UCIP_FA_2017_38623_70781.jpg

Pipe at inlet on LS shoulder.

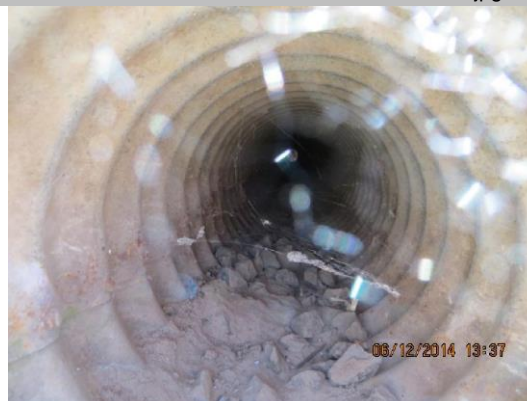
Photo 3 of 3 : UCIP_FA_2017_38623_70780.jpg

Inside pipe at LS toe.

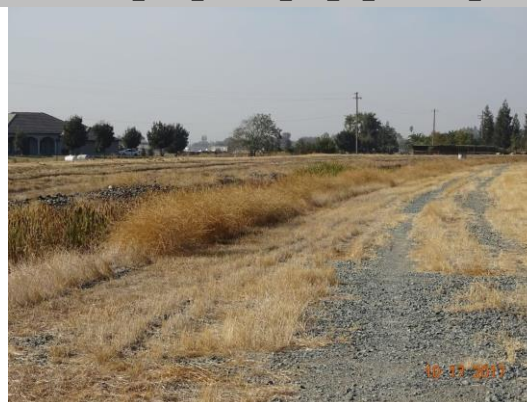
Photo 1 of 1 : FA_2017_NA0017_158_18_20171023_00080.jpg

LM Start	0.02	Rating **	M	Issue No.	18
LM End	0.54	Issue Type +	Ma	Location *	WS
Category	Earthen Levee			GPS Latitude/Longitude	
				Start	End
Item	Vegetation			38.109670 °	38.111336 °
				-121.159889 °	-121.151009 °
DWR ID	DWR_NA0017_14_f_2017_18				
Comment Code					
V1 : Control annual grass and weeds on the levee slopes and easements.					
Inspector Comment

View of the vegetation on the waterside of the levee. Fall 2017

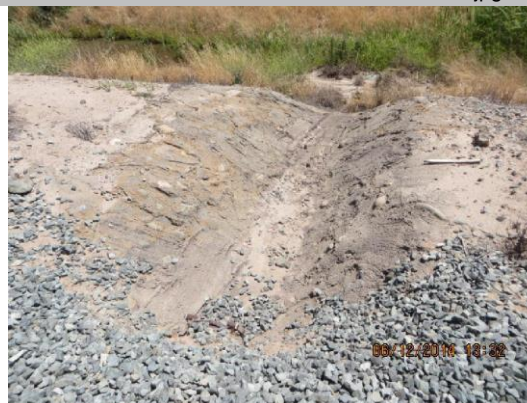
Photo 1 of 3 : UCIP_FA_2017_38615_70778.jpg

LM Start	0.25	Rating **	M	Issue No.	23
LM End	0.25	Issue Type +	Ma	Location *	
Category	Supplemental			GPS Latitude/Longitude	
				Start	End
Item	DWR UCIP LMA Responsibility			38.109799 °	38.109799 °
				-121.155621 °	-121.155621 °
DWR ID					
Comment Code					
Inspector Comment					
FS_ID:38615					
DS_ID:23940					
EP_NO: N/A					
Repair Type: Non-Urgent					
Crossing Status: Found					
UCIP Comments: Debris partially blocking closure of flapgate.					
FIELD_STRUCT_DESC: 12-inch corrugated metal drainage pipe					
through the levee, 3 feet below the crown. Flap gate on the waterside					
(WS) end. Cobble grouted spillway. [Additional Reference(s): DWR					
Levee Log, 1978. USACE San Joaquin O&M Manual 612.2, 1967, (HLM					
0.25)].					
FS Date: 6/12/2014

Pipe, flapgate, and grouted spillway on WS slope.

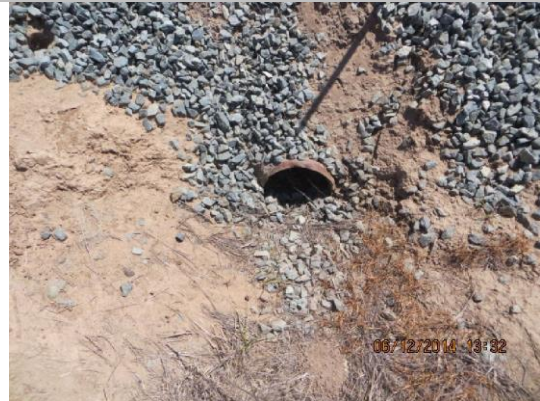
Photo 3 of 3 : UCIP_FA_2017_38615_70776.jpg

Pipe at inlet on LS shoulder.

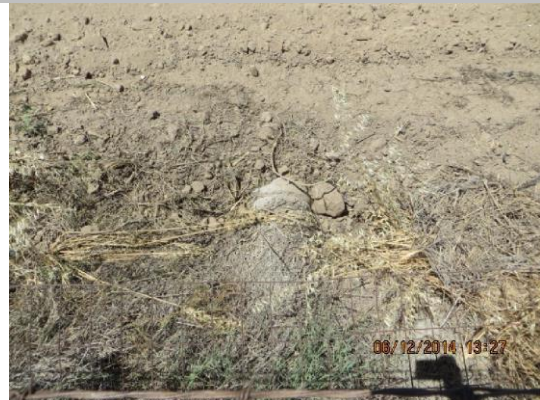
Photo 1 of 3 : UCIP_FA_2017_38614_70774.jpg

LM Start	0.37	Rating **	M	Issue No.	24
LM End	0.37	Issue Type +	Ma	Location *	
Category	Supplemental			GPS Latitude/Longitude	
				Start	End
Item	DWR UCIP LMA Responsibility			38.109855 °	38.109855 °
				-121.153390 °	-121.153390 °
DWR ID					
Comment Code					
Inspector Comment					
FS_ID:38614					
DS_ID:23941					
EP_NO: N/A					
Repair Type: Non-Urgent					
Crossing Status: Found					
UCIP Comments: Pipe buried on WS slope.					
FIELD_STRUCT_DESC: 12-inch corrugated metal drainage pipe through the levee, 1 foot below the crown. Flap gate on the waterside (WS) end. Cobble grouted spillway. [Additional Reference(s): DWR Levee Log, 1978. USACE San Joaquin O&M Manual 612.2, 1967, (HLM 0.38)].					
FS Date: 6/12/2014

Pipe just visible on LS shoulder.

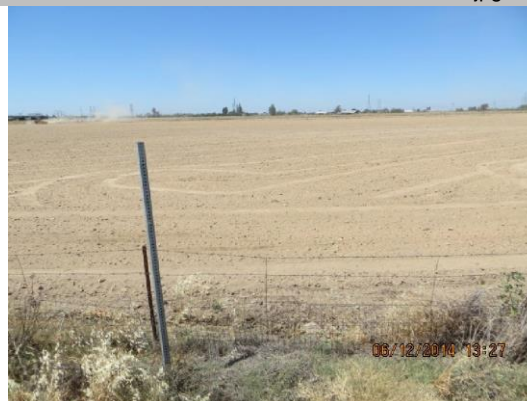
Photo 2 of 3 : UCIP_FA_2017_38614_70773.jpg

Pipe just visible on LS shoulder.

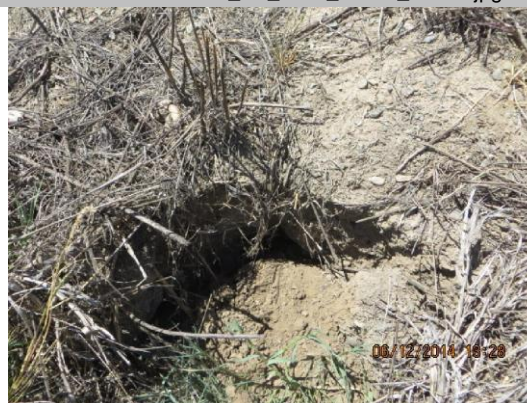
Photo 3 of 3 : UCIP_FA_2017_38614_70772.jpg

Pipe buried on WS slope.

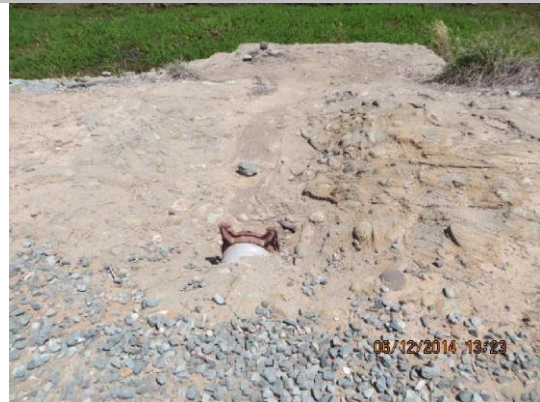
Photo 1 of 3 : UCIP_FA_2017_38613_70771.jpg

LM Start	0.46	Rating **	A/W	Issue No.	25
LM End	0.46	Issue Type +	Ma	Location *	
Category	Supplemental			GPS Latitude/Longitude	
				Start	End
Item	DWR UCIP LMA Responsibility			38.110456 °	38.110456 °
				-121.152083 °	-121.152083 °
DWR ID					
Comment Code					
Inspector Comment					
FS_ID:38613					
DS_ID:23942					
EP_NO: N/A					
Repair Type: No Action Needed					
Crossing Status: Found					
UCIP Comments:					
FIELD_STRUCT_DESC: 12-inch corrugated metal drainage pipe through the levee, 2 feet below the crown. Flap gate on the waterside (WS) end. Cobble grouted spillway. Cobble grouted intake on the landside (LS). [Additional Reference(s): DWR Levee Log, 1978. USACE San Joaquin O&M Manual 612.2, 1967, (HLM 0.46)].					
FS Date: 6/12/2014

Flapgate, pipe, and grouted spillway on WS slope.

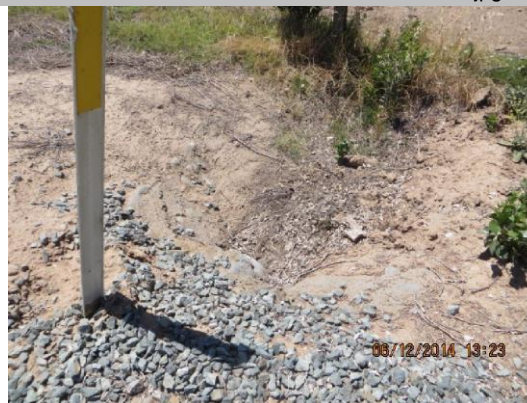
Photo 2 of 3 : UCIP_FA_2017_38613_70770.jpg

Inlet on LS shoulder.

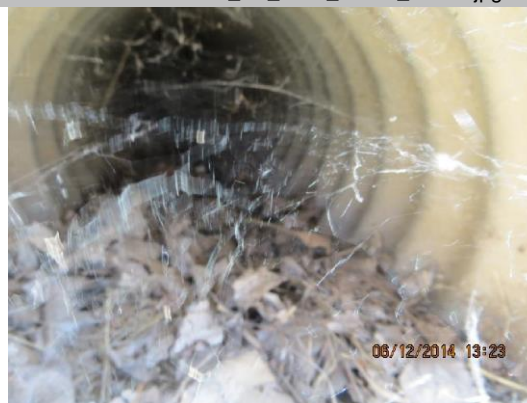
Photo 3 of 3 : UCIP_FA_2017_38613_70769.jpg

Inside pipe at LS shoulder.

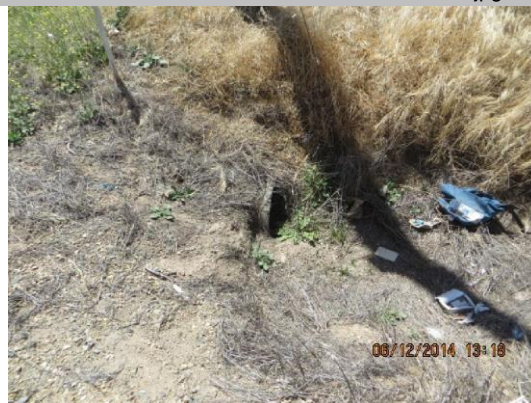
Photo 1 of 3 : UCIP_FA_2017_51407_70768.jpg

FS_ID:51407
DS_ID:23943
EP_NO: N/A
Repair Type: Urgent
Crossing Status: Found
UCIP Comments: 11/04/2016 Same as previous inspection. Crossing remains Urgent crossing opened on both sides. (O. Magana - DWR UCIP)06/12/2014 Pipe inlet and outlet partially blocked by sediment. No flapgate. (W. Wylie - DWR UCIP)
FIELD_STRUCT_DESC: 18-inch corrugated metal drainage pipe through the levee, 2.5 feet below the crown. Pipe is opened on both the waterside (WS) and landside (LS). Cobble grouted spillway is located on WS.[Additional Reference(s): DWR Levee Log, 1977, 1978, 1987, 1990. USACE San Joaquin O&M Manual Unit 612, Part No. 2 - Bear Creel Project, Unit 7: HLM 7.19 – 16.77, Unit 8: HLM 7.55-16.48, Unit 9: HLM 0.10-1.52; Unit 10: HLM 0.03-1.35, Unit 11: HLM 0.16-3.55, Unit 12: HLM 0.14-3.91; Unit 13, HLM 0.03-1.18; Unit 14, HLM 0.02-1.17, 1967, (HLM 0.55)]
FS Date: 11/4/2016 8:29:00 AM

Pipe on LS toe.

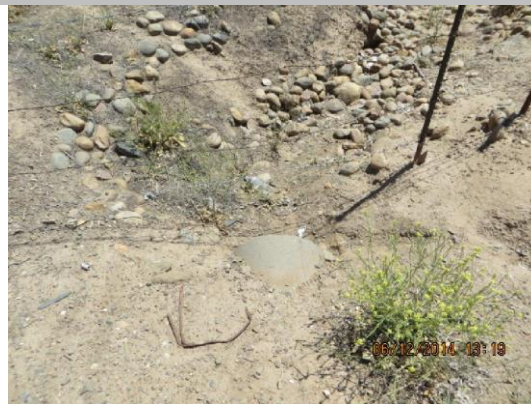
Photo 2 of 3 : UCIP_FA_2017_51407_70767.jpg

Pipe on WS shoulder.

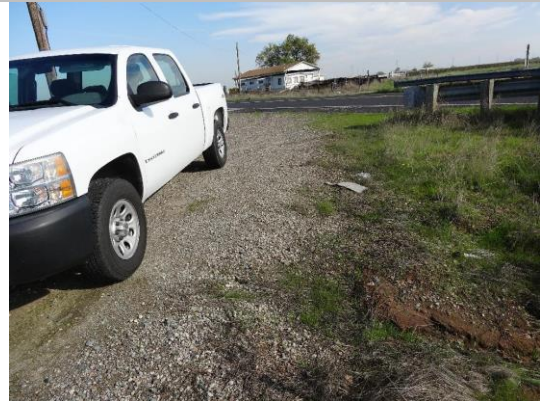
Photo 3 of 3 : UCIP_FA_2017_51407_76739.jpg

FS_ID:51407
DS_ID:23943
EP_NO: N/A
Repair Type: Urgent
Crossing Status: Found
UCIP Comments: 11/04/2016 Same as previous inspection. Crossing remains Urgent crossing opened on both sides. (O. Magana - DWR UCIP)06/12/2014 Pipe inlet and outlet partially blocked by sediment. No flapgate. (W. Wylie - DWR UCIP)
FIELD_STRUCT_DESC: 18-inch corrugated metal drainage pipe through the levee, 2.5 feet below the crown. Pipe is opened on both the waterside (WS) and landside (LS). Cobble grouted spillway is located on WS.[Additional Reference(s): DWR Levee Log, 1977, 1978, 1987, 1990. USACE San Joaquin O&M Manual Unit 612, Part No. 2 - Bear Creel Project, Unit 7: HLM 7.19 – 16.77, Unit 8: HLM 7.55-16.48, Unit 9: HLM 0.10-1.52; Unit 10: HLM 0.03-1.35, Unit 11: HLM 0.16-3.55, Unit 12: HLM 0.14-3.91; Unit 13, HLM 0.03-1.18; Unit 14, HLM 0.02-1.17, 1967, (HLM 0.55)]
FS Date: 11/4/2016 8:29:00 AM

Overview of levee crown at pipe crossing.

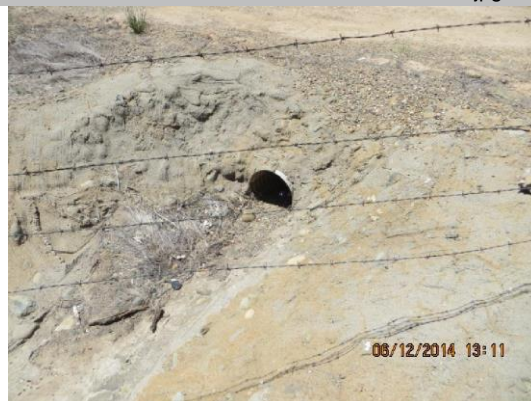
Photo 1 of 3 : UCIP_FA_2017_38610_70764.jpg

LM Start	0.56	Rating **	A/W	Issue No.	29	
LM End	0.56	Issue Type +	Ma	Location *		
Category	Supplemental			GPS Latitude/Longitude		
				Start	End	
Item	DWR UCIP LMA Responsibility			38.111507 °	38.111507 °	
				-121.150745 °	-121.150745 °	
DWR ID						
Comment Code						
Inspector Comment						
FS_ID:38610						
DS_ID:23944						
EP_NO: N/A						
Repair Type: No Action Needed						
Crossing Status: Found						
UCIP Comments:						
FIELD_STRUCT_DESC: 18-inch corrugated metal drainage pipe under the road, 2.5 feet below the crown. Open on both ends. Cobble grouted spillway. Cobble grouted intake on the landside (LS). [Additional Reference(s): DWR Levee Log, 1978. USACE San Joaquin O&M Manual 612.2, 1967, (HLM 0.57)].						
FS Date: 6/12/2014

Pipe and grouted spillway on WS

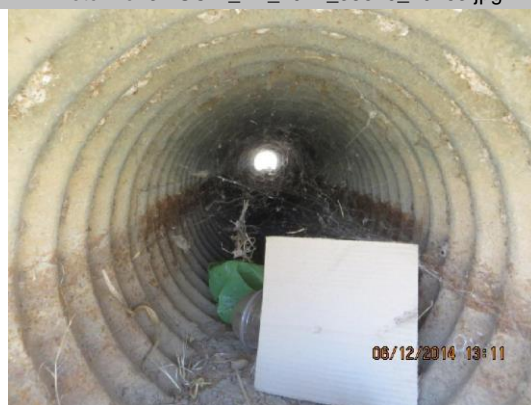
Photo 2 of 3 : UCIP_FA_2017_38610_70763.jpg

Inside pipe at LS toe.

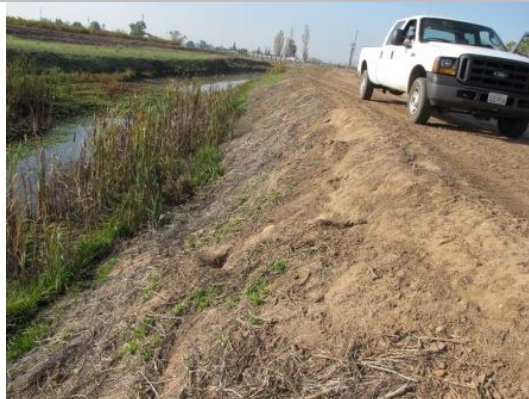
Photo 2 of 2 : FA_2017_NA0017_158_1_20170921_00002.jpg

LM Start	0.64	Rating **	M	Issue No.	1 (cont)	
LM End	0.64	Issue Type +	Ma	Location *	WS	
Category	Earthen Levee			GPS Latitude/Longitude		
				Start		End
Item	Animal Control			38.112050 °		38.112050 °
				-121.149524 °		-121.149524 °
DWR ID	DWR_NA0017_14_s_2012_1					
Comment Code						
A1 : Exterminate rodents and backfill and compact or grout burrows.						
Inspector Comment

View of rodent holes in the waterward berm looking downstream.

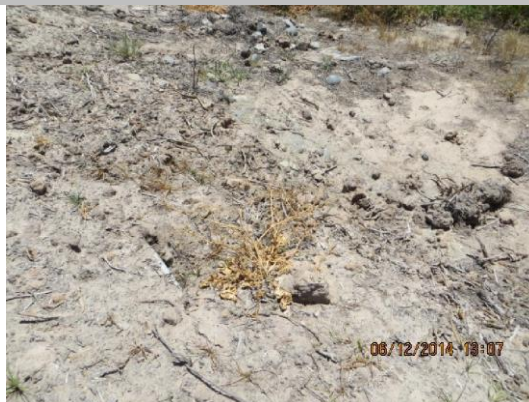
Photo 1 of 3 : UCIP_FA_2017_41365_70758.jpg

LM Start	0.75	Rating **	M	Issue No.	30
LM End	0.75	Issue Type +	Ma	Location *	
Category	Supplemental			GPS Latitude/Longitude	
				Start	End
Item	DWR UCIP LMA Responsibility			38.111475 °	38.111475 °
				-121.148081 °	-121.148081 °
DWR ID					
Comment Code					
Inspector Comment					
FS_ID:41365					
DS_ID:23945					
EP_NO: N/A					
Repair Type: Non-Urgent					
Crossing Status: Found					
UCIP Comments: Pipe open on both ends. Levee appears abandoned.					
FIELD_STRUCT_DESC: 24-inch corrugated metal drainage pipe					
through the levee, 1 foot below the crown. Cobble grouted spillway.					
Cobble grouted intake on the landside (LS). Open on both ends.					
[Additional Reference(s): DWR Levee Log, 1978. USACE San Joaquin					
O&M Manual 612.2, 1967, (HLM 0.76)].					
FS Date: 6/12/2014

Pipe on WS slope.

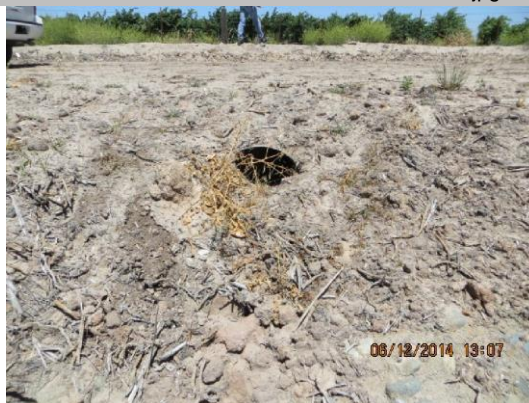
Photo 2 of 3 : UCIP_FA_2017_41365_70757.jpg

Pipe on WS slope.

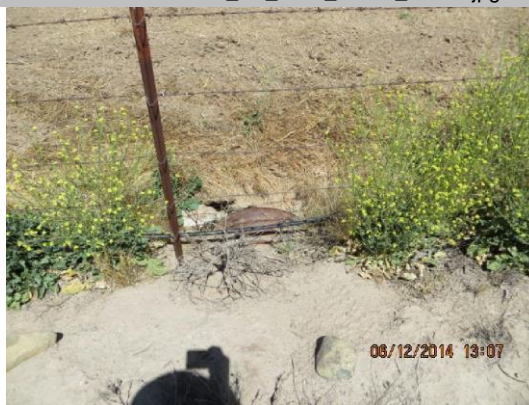
Photo 3 of 3 : UCIP_FA_2017_41365_70756.jpg

Pipe on LS shoulder.

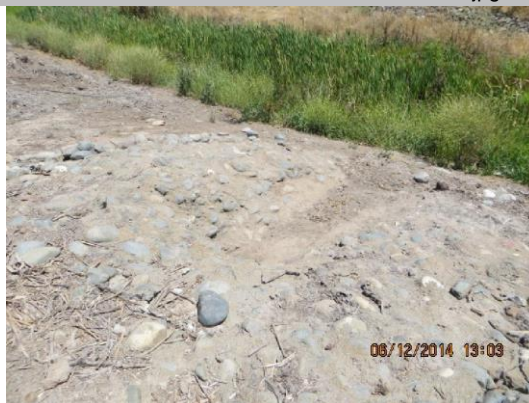
Photo 1 of 3 : UCIP_FA_2017_41791_70755.jpg

LM Start	0.94	Rating **	M	Issue No.	31
LM End	0.94	Issue Type +	Ma	Location *	
Category	Supplemental			GPS Latitude/Longitude	
				Start	End
Item	DWR UCIP LMA Responsibility			38.110801 °	38.110801 °
				-121.145174 °	-121.145174 °
DWR ID					
Comment Code					
Inspector Comment					
FS_ID:41791					
DS_ID:23946					
EP_NO: N/A					
Repair Type: Non-Urgent					
Crossing Status: Found					
UCIP Comments: Pipe buried on LS. Levee appears abandoned.					
FIELD_STRUCT_DESC: *ABANDONED* 12-inch corrugated metal drainage pipe through the levee, 2 feet below the crown. Open on both ends. Cobble grouted spillway. [Additional Reference(s): DWR Levee Log, 1978. USACE San Joaquin O&M Manual 612.2, 1967, (HLM 0.95)].					
FS Date: 6/12/2014

Pipe and grouted spillway on WS slope.

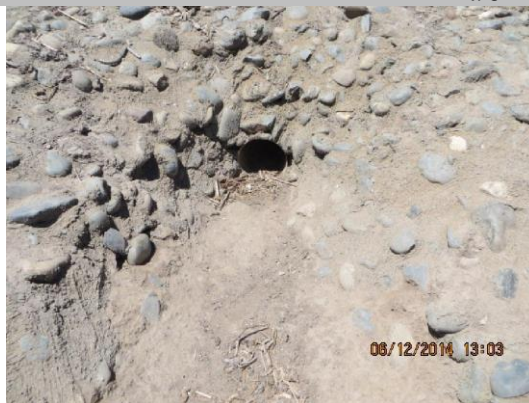
Photo 2 of 3 : UCIP_FA_2017_41791_70754.jpg

Pipe and grouted spillway on WS slope.

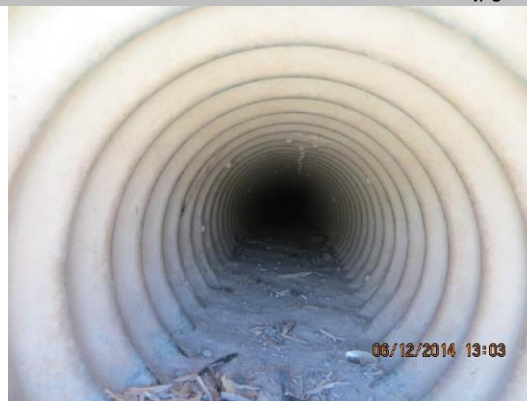
Photo 3 of 3 : UCIP_FA_2017_41791_70753.jpg

LM Start	0.94	Rating **	M	Issue No.	31 (cont)	
LM End	0.94	Issue Type +	Ma	Location *		
Category	Supplemental			GPS Latitude/Longitude		
				Start	End	
Item	DWR UCIP LMA Responsibility			38.110801 °	38.110801 °	
				-121.145174 °	-121.145174 °	
DWR ID						
Comment Code						
Inspector Comment						
FS_ID:41791						
DS_ID:23946						
EP_NO: N/A						
Repair Type: Non-Urgent						
Crossing Status: Found						
UCIP Comments: Pipe buried on LS. Levee appears abandoned.						
FIELD_STRUCT_DESC: *ABANDONED* 12-inch corrugated metal drainage pipe through the levee, 2 feet below the crown. Open on both ends. Cobble grouted spillway. [Additional Reference(s): DWR Levee Log, 1978. USACE San Joaquin O&M Manual 612.2, 1967, (HLM 0.95)].						
FS Date: 6/12/2014

Inside pipe at WS slope.

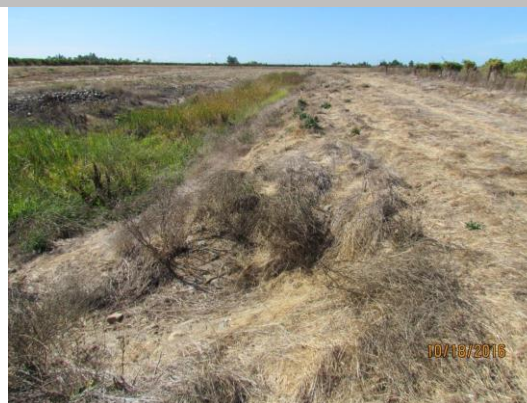
Photo 1 of 1 : FA_2017_NA0017_158_20_20170921_00006.jpg

LM Start	0.96	Rating **	M	Issue No.	20
LM End	0.96	Issue Type +	Ma	Location *	WS
Category	Earthen Levee			GPS Latitude/Longitude	
				Start	End
Item	Erosion / Bank Caving			38.110896 °	38.110896 °
				-121.144791 °	-121.144791 °
DWR ID	DWR_NA0017_14_f_2016_20				
Comment Code					
E2 : Schedule repair of erosion site prior to the next inspection.					
Inspector Comment

View of the erosion on the waterside of the levee. Fall 2016.

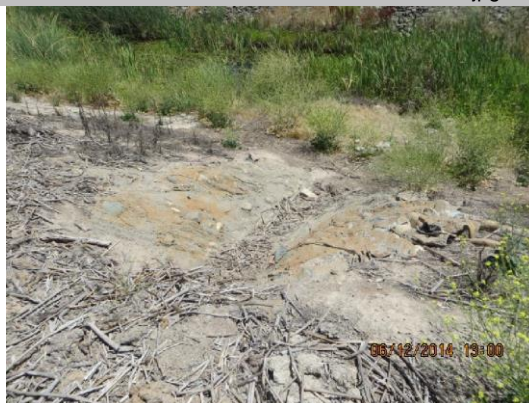
Photo 1 of 2 : UCIP_FA_2017_41792_70752.jpg

LM Start	0.96	Rating **	M	Issue No.	32
LM End	0.96	Issue Type +	Ma	Location *	
Category	Supplemental			GPS Latitude/Longitude	
				Start	End
Item	DWR UCIP LMA Responsibility			38.110926 °	38.110926 °
				-121.144799 °	-121.144799 °
DWR ID					
Comment Code					
Inspector Comment					
FS_ID:41792					
DS_ID:23947					
EP_NO: N/A					
Repair Type: Non-Urgent					
Crossing Status: Found					
UCIP Comments: Pipe burried on LS shoulder and open on WS.					
Levee appears abandoned.					
FIELD_STRUCT_DESC: *ABANDONED* 18-inch corrugated metal drainage pipe through the levee, 3 feet below the crown. Open on both ends. Cobble grouted spillway. Cobble grouted intake on the landside (LS). [Additional Reference(s): DWR Levee Log, 1978. USACE San Joaquin O&M Manual 612.2, 1967, (HLM 0.97)].					
FS Date: 6/12/2014

Pipe and grouted spillway on WS slope.

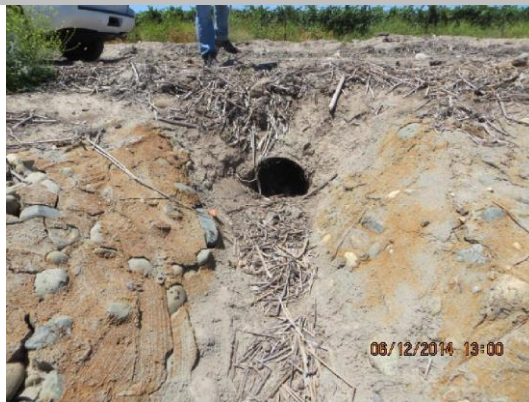
Photo 2 of 2 : UCIP_FA_2017_41792_70751.jpg

Pipe and grouted spillway on WS slope.

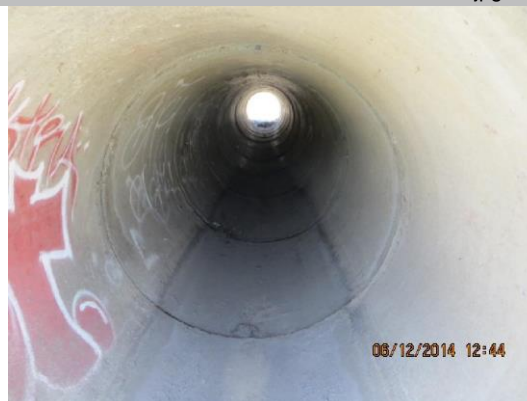
Photo 2 of 3 : UCIP_FA_2017_41794_70741.jpg

Inside pipe.

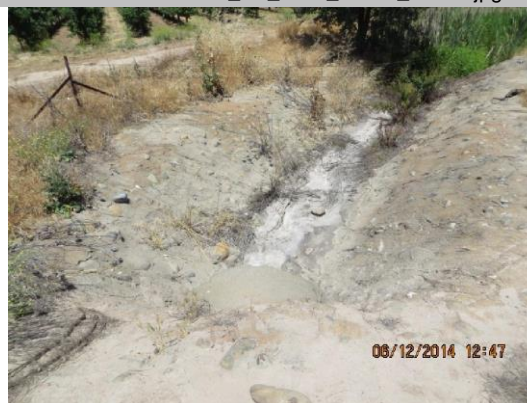
Photo 3 of 3 : UCIP_FA_2017_41794_70740.jpg

Pipe at LS intake.

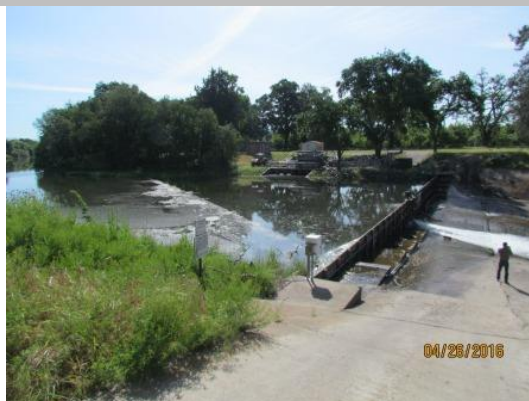
Photo 1 of 1 : FA_2017_NA0017_159_1155_20170921_00140.jpg

LM Start	0.00	Rating **	A/W	Issue No.	1155
LM End	0.00	Issue Type +	Ma	Location *	WS
Category	Interior Drainage & Piping Systems			GPS Latitude/Longitude	
				Start	End
Item	Vegetation & Obstructions			0.000000 °	0.000000 °
				0.000000 °	0.000000 °
DWR ID	DWR_NA0017_15_s_2014_1155				
Comment Code					
Inspector Comment					
This is the Upper Calaveras river channel. No levee exists.

View of the dam at the starting of the Mormon slough.

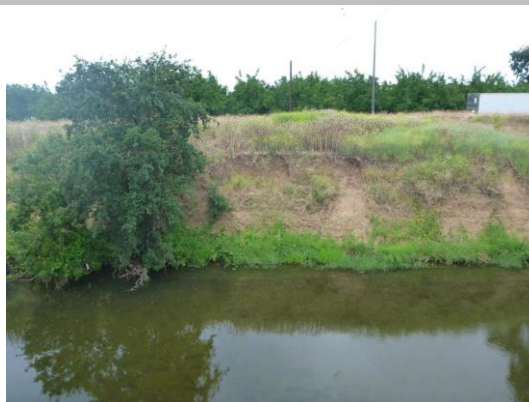
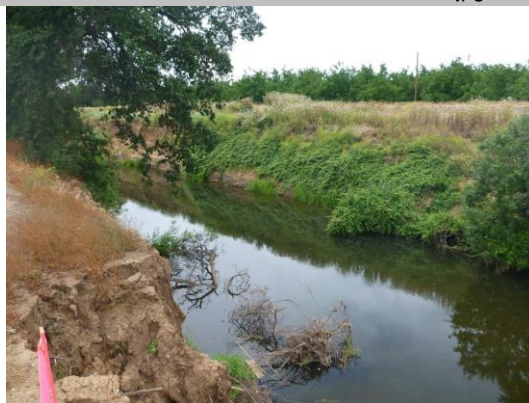
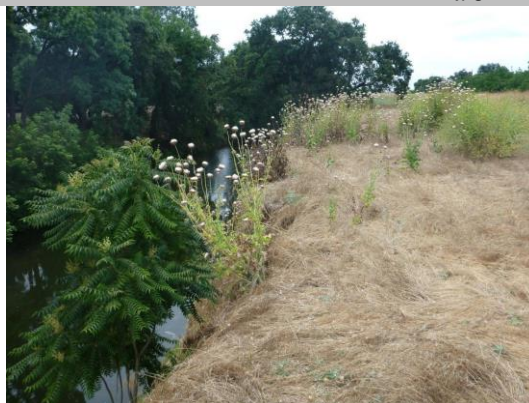
LM Start	0.26	Rating **	A/W	Issue No.	155
LM End	1.06	Issue Type +	Ma	Location *	
Category	Supplemental			GPS Latitude/Longitude	
				Start	End
Item	2017 Storm Damage			38.049780 °	38.043090 °
				-121.014681 °	-121.026200 °
DWR ID	DWR_NA0017_15_f_2017_155				
Comment Code					
Inspector Comment					
Levee Evaluation Comments					
Description:					
Site ID No:83					
Site Designation:DWR_NA0017_15_s_2012_10					
Repair Type: Erosion					
Rating:Area of Concern					
Field Date:6/7/2017					
Notes: Channel incising is cutting near vertical slopes almost 20' high.					
Bank along site has between 30' to 10' remaining. This site is currently					
under contract for repair by FSRP.

Notes: Channel incising is cutting near vertical slopes almost 20' high. Bank along site has between 30' to 10' remaining. This site is currently under contract for repair by FSRP.

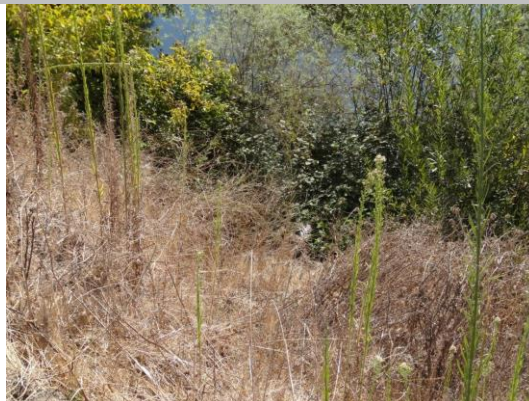
Photo 1 of 4 : SJR2017_NA0017U15RM22.91_1.jpg

Comment Code					
Inspector Comment					
08/30/2017: No significant change observed.					
08/16/2016: No significant change observed.					
08/12/2015: No significant change observed.					
08/20/2014: No significant change has been observed.					
09/12/2013: No significant change observed.					
08/22/2012: Site has been revisited. No significant change observed.					
09/02/2011: No significant change observed on site.					
11/02/2010: No significant change observed. The mile-long erosion continues to degrade the bank. There are a few trees along the mile-long stretch on the lower bank slope that are affected by the scarp. WS Levee Slope was changed to 2:1. As a result, normalized score increased from 62 to 65.					
08/05/2010: Recommended for waterside repair, per CLRO; "water velocity is a major factor for accelerating bank slope erosion."					
8/12/2009: Near-vertical bank erosion; degrading channel is incising the banks; recommend annual assessment and monitoring of critical erosion site, per CLRO CES Evaluation 2008 Report; district is monitoring site for change in condition; site was previously rated "U".

Looking at the site from the levee top.

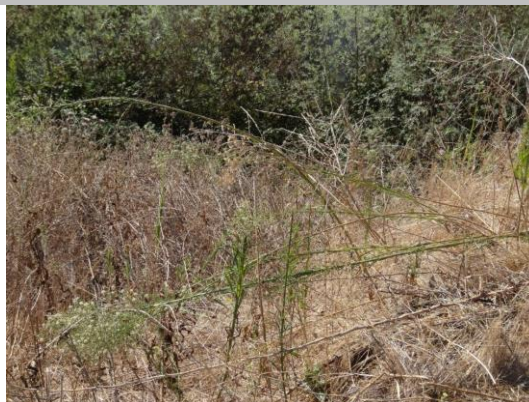
Photo 2 of 4 : SJR2017_NA0017U15RM22.91_2.jpg

Close view of the erosion. Note dense vegetation and trees on site.

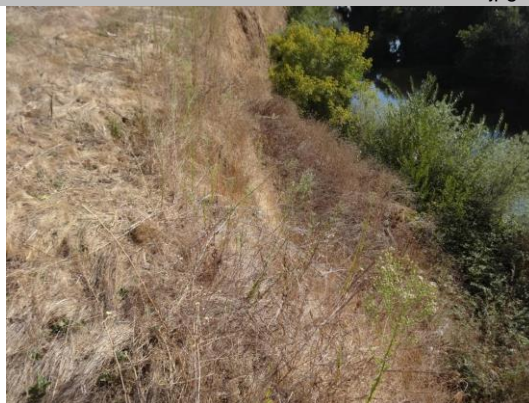
Photo 3 of 4 : SJR2017_NA0017U15RM22.91_3.jpg

8/12/2009: Near-vertical bank erosion; degrading channel is incising the banks; recommend annual assessment and monitoring of critical erosion site, per CLRO CES Evaluation 2008 Report; district is monitoring site for change in condition; site was previously rated "U".						
2007: Visited site 02/06/2007; possible critical site. [2017 Site ID:NA0017U15RM22.91]

Close view of the erosion.

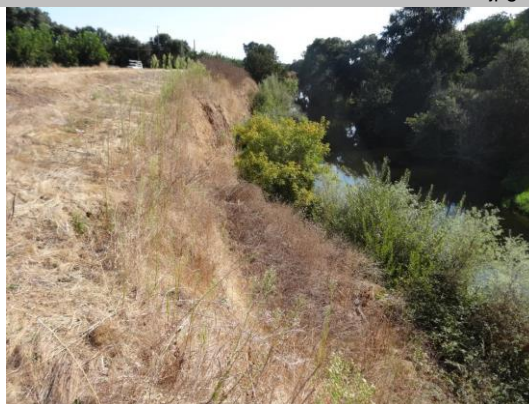
Photo 4 of 4 : SJR2017_NA0017U15RM22.91_4.jpg

Looking upstream at the site.
