**Flood Control Project Maintenance
Levee Inspections**

Maintenance Issue Types Only, Levee Inspection Report By Mile - Fall 2017

San Joaquin County Flood Control and Water Conservation District

Waterway	Bank	Unit Miles	Inspection Start/End	Inspector
Unit No. 01 Littlejohn Creek	Left	2.59	10/17/2017 10/17/2017	Pavel Kazi

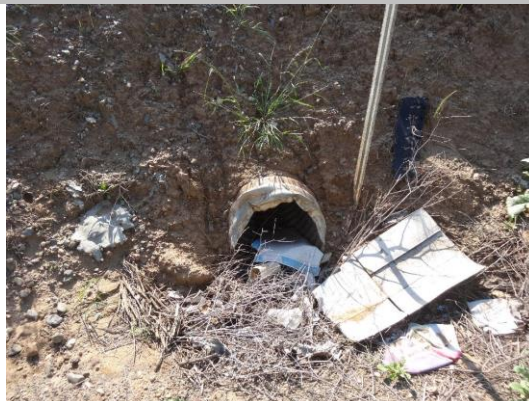
Photo 2 of 2 : UCIP_FA_2017_34877_62778.jpg

LM Start	1.16	Rating **	M	Issue No.	1158 (cont)	
LM End	1.16	Issue Type +	Ma	Location *		
Category	Supplemental			GPS Latitude/Longitude		
				Start	End	
Item	DWR UCIP LMA Responsibility			38.041907 °	38.041907 °	
				-121.027235 °	-121.027235 °	
DWR ID						
Comment Code						
Inspector Comment						
FS_ID:34877						
DS_ID:23199						
EP_NO: N/A						
Repair Type: Non-Urgent						
Crossing Status: Found						
UCIP Comments: Deformed inlet opening. Needs cleaning and clearing on inlet opening on landside.						
FIELD_STRUCT_DESC: 18-inch corrugated metal drainage pipe through the levee, 4.5 feet below the crown. Grouted spillway on the waterside (WS) end. Open on both ends. [Additional Reference(s): DWR Levee Log, 1992. USACE San Joaquin O&M Manual 611.1, Volume F, (HLM 1.18)].						
FS Date: 4/9/2014

LS view: CM inlet pipe. Pipe opening obstructed with debris.

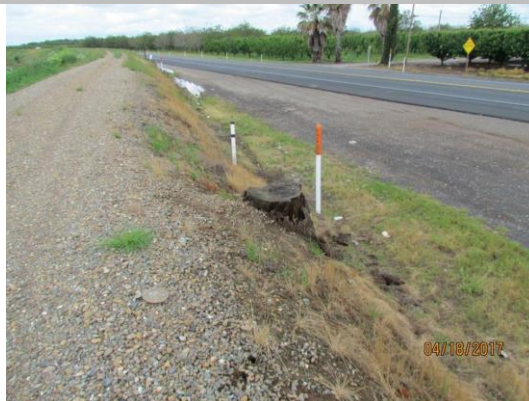
Photo 1 of 1 : FA_2017_NA0017_159_1128_20170921_00139.jpg

LM Start	1.45	Rating **	N	Issue No.	1128
LM End	1.45	Issue Type +	Ma	Location *	LS
Category	Earthen Levee			GPS Latitude/Longitude	
				Start	End
Item	Trim / Thin Trees			38.040188 °	38.040188 °
				-121.031854 °	-121.031854 °
DWR ID	DWR_NA0017_15_s_2012_1128				
Comment Code					
T5 : Tree stumps.					
Inspector Comment

View of a tree stump on the landside shoulder of the levee.

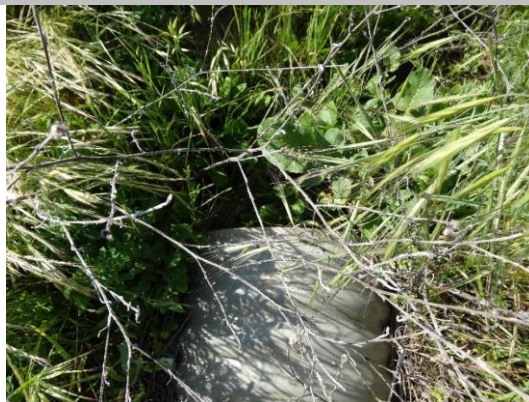
Photo 1 of 3 : UCIP_FA_2017_40369_62785.jpg

LM Start	1.46	Rating **	M	Issue No.	1159
LM End	1.46	Issue Type +	Ma	Location *	
Category	Supplemental			GPS Latitude/Longitude	
				Start	End
Item	DWR UCIP LMA Responsibility			38.040197 °	38.040197 °
				-121.032044 °	-121.032044 °
DWR ID					
Comment Code					
Inspector Comment					
FS_ID:40369 DS_ID:23200 EP_NO: N/A Repair Type: Non-Urgent Crossing Status: Found UCIP Comments: Pipe needs cleaning and clearing on both pipe ends. FIELD_STRUCT_DESC: 18-inch drainage pipe of an unknown material through the levee, 6 feet below the crown. Grouted spillway on the waterside (WS) end. Electrical conduit through the levee. [Additional Reference(s): DWR Levee Log, 1992. USACE San Joaquin O&M Manual 611.1, Volume F, (HLM 1.49)]. FS Date: 4/9/2014

WS view: outlet CM pipe on levee slope.

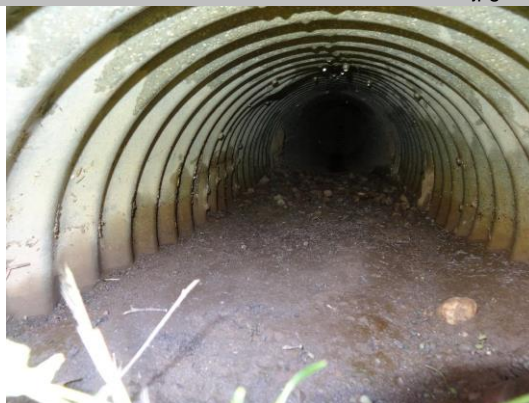
Photo 2 of 3 : UCIP_FA_2017_40369_62784.jpg

FS_ID:40369
DS_ID:23200
EP_NO: N/A
Repair Type: Non-Urgent
Crossing Status: Found
UCIP Comments: Pipe needs cleaning and clearing on both pipe ends.
FIELD_STRUCT_DESC: 18-inch drainage pipe of an unknown material through the levee, 6 feet below the crown. Grouted spillway on the waterside (WS) end. Electrical conduit through the levee. [Additional Reference(s): DWR Levee Log, 1992. USACE San Joaquin O&M Manual 611.1, Volume F, (HLM 1.49)].
FS Date: 4/9/2014

WS view: inside view of the outlet pipe. Needs cleaning and clearing.

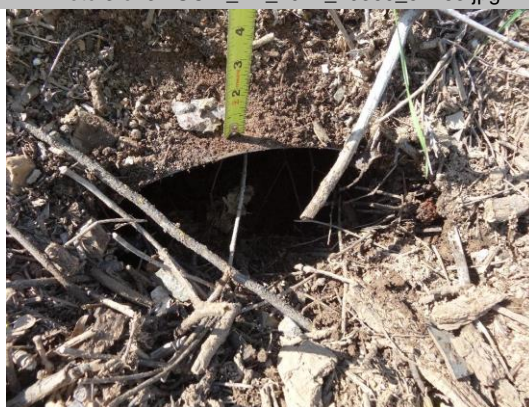
Photo 3 of 3 : UCIP_FA_2017_40369_62783.jpg

LS view: buried inlet pipe. Needs cleaning and clearing.

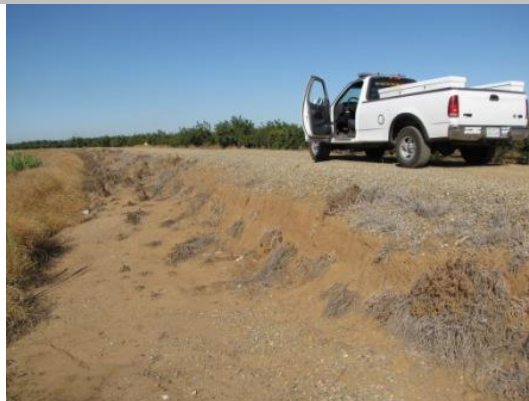
Photo 1 of 1 : FA_2017_NA0017_159_995_20170921_00124.jpg

LM Start	1.49	Rating **	M	Issue No.	995	
LM End	1.49	Issue Type +	Ma	Location *	WS	
Category	Earthen Levee			GPS Latitude/Longitude		
				Start		End
Item	Slope Stability			38.040202 °		38.040202 °
				-121.032659 °		-121.032659 °
DWR ID	DWR_NA0017_15_s_2012_995					
Comment Code						
S1 : Repair slope instability.						
Inspector Comment						
The LMA was working on fixing the erosion site using an excavator during the spring 2016 inspection. The erosion repair was not completed spring 2017 inspection.

View of erosion of waterward levee slope looking upstream.

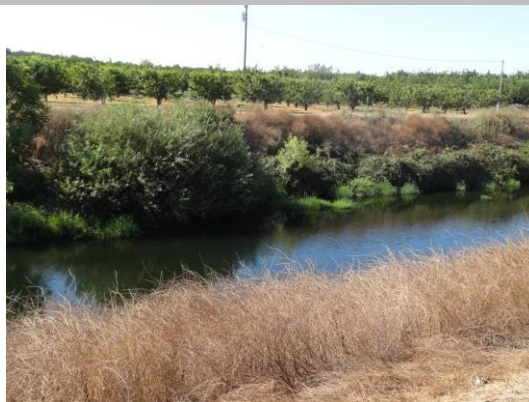
Photo 1 of 4 : SJR2017_NA0017U15RM22.01_1.jpg

LM Start	1.78	Rating **	U	Issue No.	6
LM End	1.79	Issue Type +	Ma	Location *	WS
Category	Supplemental			GPS Latitude/Longitude	
				Start	End
Item	DWR Erosion Survey			38.039110 °	38.039110 °
				-121.037840 °	-121.037840 °
DWR ID	NA0017U15RM22.01				
Comment Code					
Inspector Comment					
08/30/2017: No significant change observed. 08/16/2016: No significant change observed. 08/12/2015: No significant change observed. 08/20/2014: No significant change observed. 09/12/2013: No significant change observed. 08/22/2012: Site is covered with dense vegetation. A scarp erosion is adjacent to a pocket erosion at the downstream. There is no levee structure on site. The levee crest width and levee height were not measured or estimated in the field. [2017 Site ID:NA0017U15RM22.01]

Front view of the erosion site from the left river bank.

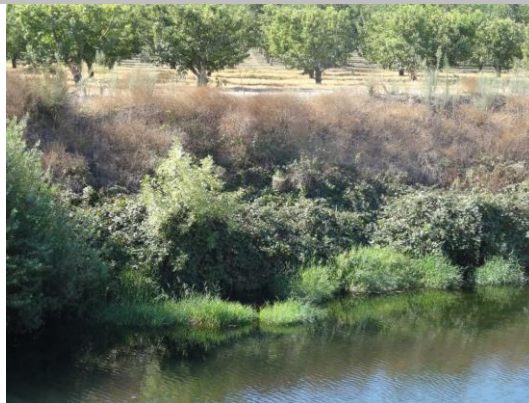
Photo 2 of 4 : SJR2017_NA0017U15RM22.01_2.jpg

Front view of the pocket erosion covered by dense vegetation.

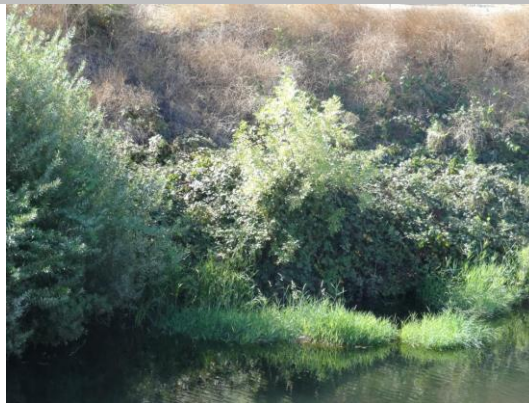
Photo 3 of 4 : SJR2017_NA0017U15RM22.01_3.jpg

Close view of the pocket erosion.

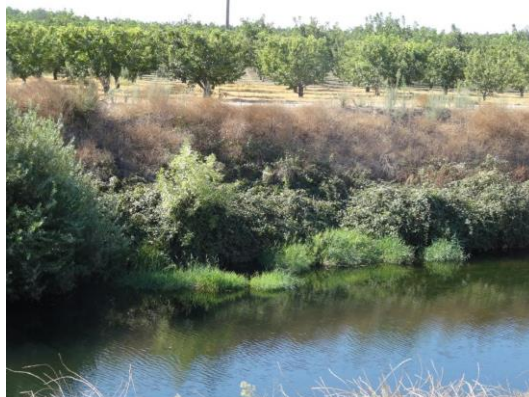
Photo 4 of 4 : SJR2017_NA0017U15RM22.01_4.jpg

Close view of the erosion.

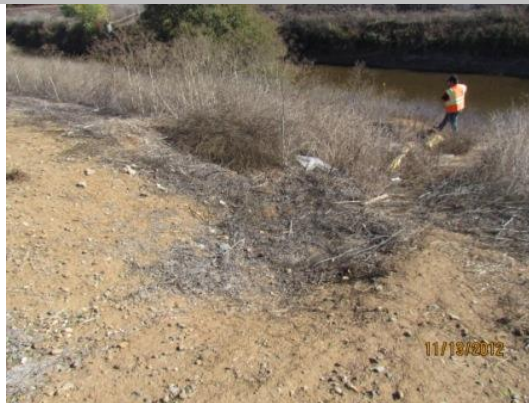
Photo 1 of 2 : FA_2017_NA0017_159_18_20170921_00015.jpg

LM Start	2.05	Rating **	M	Issue No.	18
LM End	2.05	Issue Type +	Ma	Location *	WS
Category	Earthen Levee			GPS Latitude/Longitude	
				Start	End
Item	Slope Stability			38.036294 °	38.036294 °
				-121.041089 °	-121.041089 °
DWR ID	DWR_NA0017_15_s_2012_18				
Comment Code					
S1 : Repair slope instability.					
Inspector Comment

Updated picture of the slope instability at the waterside slope of the levee looking upstream.

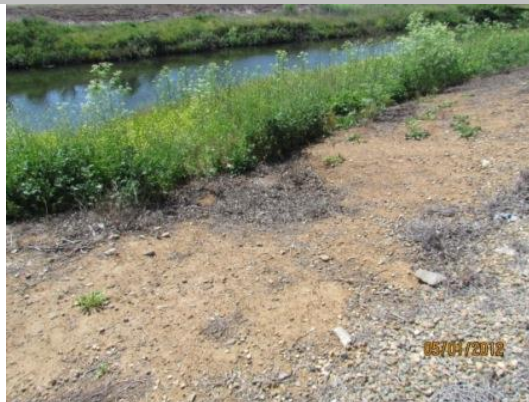
Photo 2 of 2 : FA_2017_NA0017_159_18_20170921_00016.jpg

Slope instability was found on the waterside toe of the levee looking downstream.

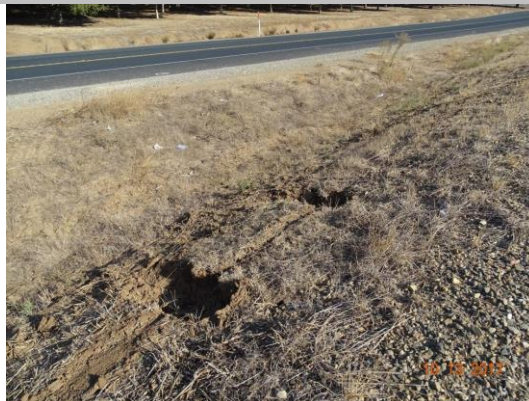
Photo 1 of 1 : FA_2017_NA0017_159_159_20171023_00433.jpg

LM Start	2.30	Rating **	M	Issue No.	159
LM End	2.30	Issue Type +	Ma	Location *	LS
Category	Earthen Levee			GPS Latitude/Longitude	
				Start	End
Item	Slope Stability			38.033687 °	38.033687 °
				-121.044156 °	-121.044156 °
DWR ID	DWR_NA0017_15_f_2017_159				
Comment Code					
S3 : Repair the levee slope damaged by vehicle traffic and prevent access where possible.					
Inspector Comment

View of a slope instability on the landside of the levee looking upstream.
Fall 2017

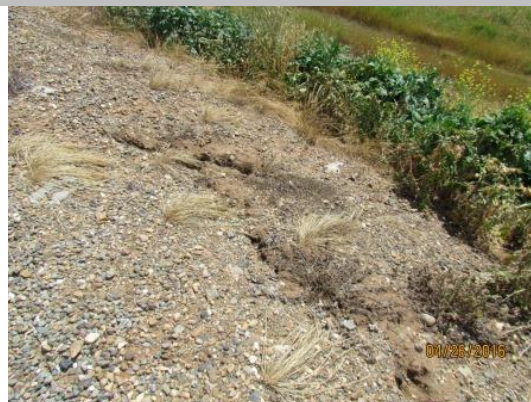
Photo 1 of 1 : FA_2017_NA0017_159_218_20170921_00109.jpg

LM Start	3.55	Rating **	M	Issue No.	218
LM End	3.55	Issue Type +	Ma	Location *	WS
Category	Earthen Levee		GPS Latitude/Longitude		
			Start	End	
Item	Animal Control		38.021701 °	38.021701 °	
			-121.061178 °	-121.061178 °	
DWR ID	DWR_NA0017_15_s_2016_218				
Comment Code					
A3 : No rodents visible, but rodent burrows visible; need to backfill and compact or grout burrows.					
Inspector Comment

View of rodent holes on the waterside of the levee looking upstream.

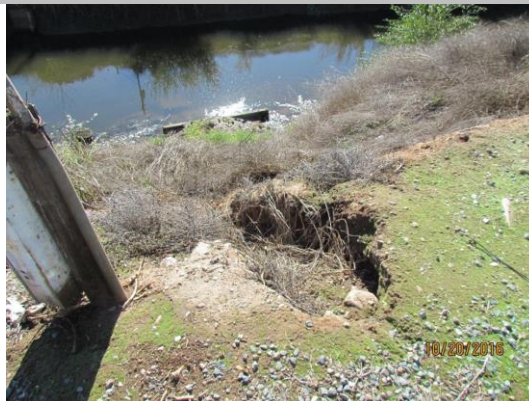
Photo 1 of 2 : FA_2017_NA0017_159_44_20170921_00032.jpg

LM Start	3.89	Rating **	M	Issue No.	44
LM End	3.89	Issue Type +	Ma	Location *	WS
Category	Earthen Levee			GPS Latitude/Longitude	
				Start	End
Item	Slope Stability			38.017945°	38.017945°
				-121.065295°	-121.065295°
DWR ID	DWR_NA0017_15_f_2012_44				
Comment Code					
S1 : Repair slope instability.					
Inspector Comment

Updated picture of the slope instability on the waterside shoulder of the levee. Fall 2016

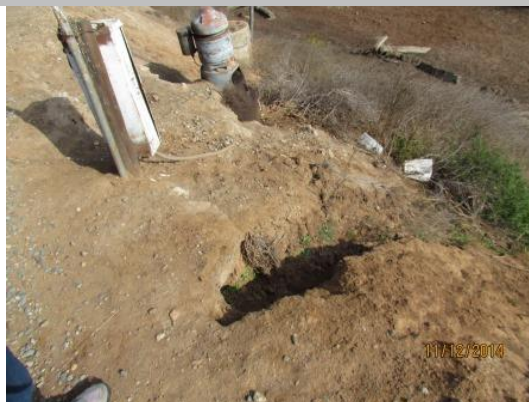
Photo 2 of 2 : FA_2017_NA0017_159_44_20170921_00033.jpg

LM Start	3.89	Rating **	M	Issue No.	44 (cont)
LM End	3.89	Issue Type +	Ma	Location *	WS

Updated picture of the slope instability on the waterside slope of the levee looking upstream. This picture was taken during fall 2014 inspection.

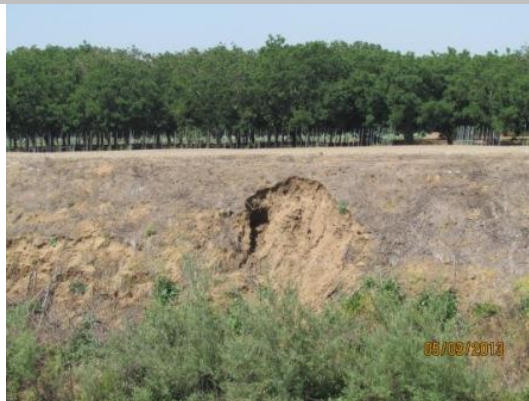
Photo 1 of 1 : FA_2017_NA0017_159_124_20170921_00073.jpg

LM Start	4.28	Rating **	U	Issue No.	124
LM End	4.28	Issue Type +	Ma	Location *	WS
Category	Earthen Levee			GPS Latitude/Longitude	
				Start	End
Item	Animal Control			38.013018 °	38.013018 °
				-121.067996 °	-121.067996 °
DWR ID	DWR_NA0017_15_s_2013_124				
Comment Code					
A3 : No rodents visible, but rodent burrows visible; need to backfill and compact or grout burrows.					
Inspector Comment					
Picture was taken from the other side of the levee.

An animal hole was found on the waterside slope of the levee. The picture was taken from the opposite side of the levee.

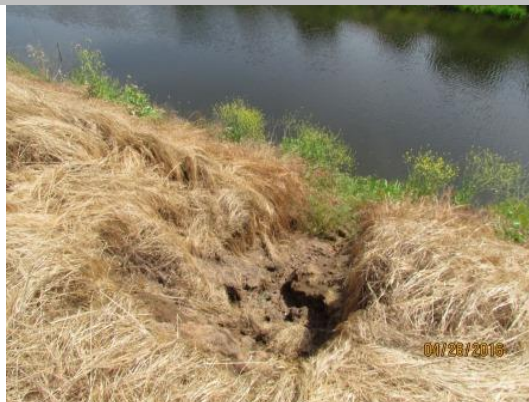
Photo 1 of 2 : FA_2017_NA0017_159_133_20170921_00075.jpg

Updated view of the erosion on the waterside shoulder during spring 2016 inspection.

LM Start	4.51	Rating **	M	Issue No.	133
LM End	4.51	Issue Type +	Ma	Location *	WS
Category	Earthen Levee			GPS Latitude/Longitude	
				Start	End
Item	Erosion / Bank Caving			38.009753 °	38.009753 °
				-121.069559 °	-121.069559 °
DWR ID	DWR_NA0017_15_f_2015_133				
Comment Code					
E2 : Schedule repair of erosion site prior to the next inspection.					
Inspector Comment

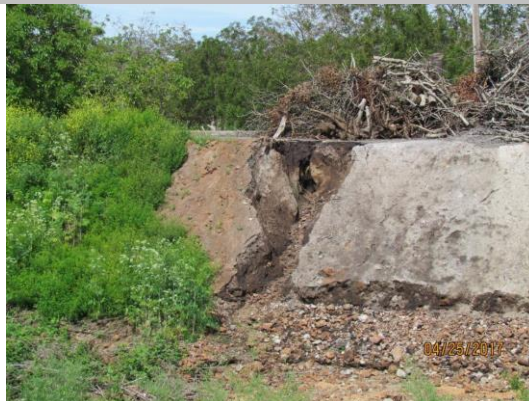
Photo 1 of 1 : FA_2017_NA0017_159_242_20170921_00119.jpg

View of an erosion on the waterside slope of the levee. The picture was taken from the opposite side of the levee. Spring 2017

LM Start	4.86	Rating **	U	Issue No.	242
LM End	4.86	Issue Type +	Ma	Location *	WS
Category	Earthen Levee			GPS Latitude/Longitude	
				Start	End
Item	Erosion / Bank Caving			38.005099 °	38.005099 °
				-121.071910 °	-121.071910 °
DWR ID	DWR_NA0017_15_s_2017_242				
Comment Code					
E2 : Schedule repair of erosion site prior to the next inspection.					
Inspector Comment

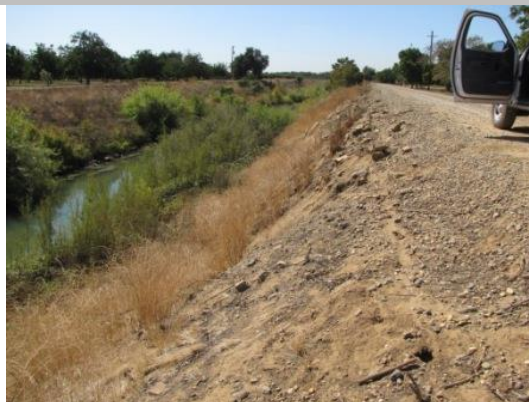
Photo 1 of 1 : FA_2017_NA0017_159_1009_20170921_00125.jpg

View of a slip in the waterward levee slope looking downstream.

LM Start	5.04	Rating **	M	Issue No.	1009
LM End	5.04	Issue Type +	Ma	Location *	WS
Category	Earthen Levee			GPS Latitude/Longitude	
				Start	End
Item	Slope Stability			38.003021 °	38.003021 °
				-121.073658 °	-121.073658 °
DWR ID	DWR_NA0017_15_s_2012_1009				
Comment Code					
S1 : Repair slope instability.					
Inspector Comment

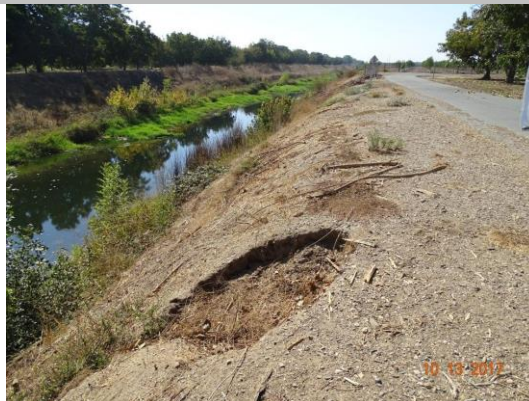
Photo 1 of 1 : FA_2017_NA0017_159_161_20171023_00436.jpg

LM Start	5.43	Rating **	A/W	Issue No.	161
LM End	5.43	Issue Type +	Ma	Location *	WS
Category	Earthen Levee			GPS Latitude/Longitude	
				Start	End
Item	Erosion / Bank Caving			37.998297 °	37.998297 °
				-121.077821 °	-121.077821 °
DWR ID	DWR_NA0017_15_f_2017_161				
Comment Code					
E1 : Note and monitor erosion site.					
Inspector Comment					
This portion of the levee is non-project. Therefore, the rating was given A/W.

View of erosion on the waterside slope of the levee. Fall 2017

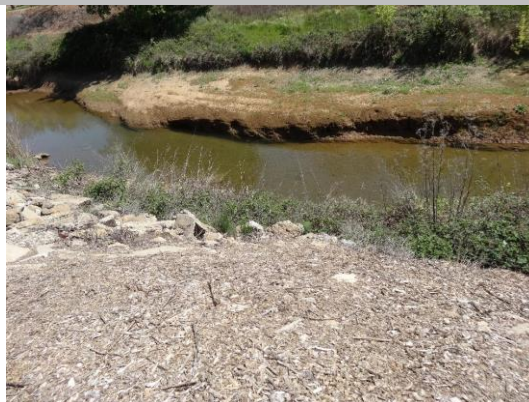
Photo 1 of 2 : UCIP_FA_2017_34924_62867.jpg

LM Start	5.46	Rating **	A/W	Issue No.	1165	
LM End	5.46	Issue Type +	Ma	Location *		
Category	Supplemental			GPS Latitude/Longitude		
				Start		End
Item	DWR UCIP LMA Responsibility			37.997990 °		37.997990 °
				-121.078092 °		-121.078092 °
DWR ID						
Comment Code						
Inspector Comment						
FS_ID:34924 DS_ID:23308 EP_NO: N/A Repair Type: No Action Needed Crossing Status: Found UCIP Comments: Inlet CM pipe riser on landside shoulder. Pipe not found on waterside. Dense vegetation on channel bank. May need inlet cleaning. FIELD_STRUCT_DESC: 18-inch corrugated metal drainage pipe, 2 feet below the roadway. Concrete rubble splash apron on the waterside (WS) end. [Additional Reference(s): DWR Levee Log, 1977. USACE San Joaquin O&M Manual 611.1, Volume F, (HLM 5.58)]. FS Date: 4/9/2014

WS view: no pipe and structure found on waterside. Dense vegetation on channel bank.

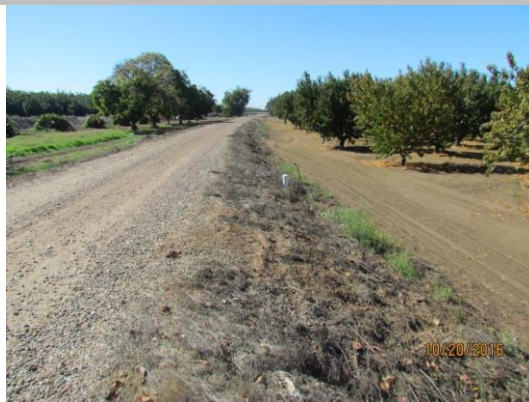
Photo 1 of 2 : FA_2017_NA0017_159_140_20170921_00078.jpg

LM Start	6.67	Rating **	A/W	Issue No.	140
LM End	6.67	Issue Type +	Ma	Location *	LS
Category	Earthen Levee			GPS Latitude/Longitude	
				Start	End
Item	Animal Control			37.983817 °	37.983817 °
				-121.091141 °	-121.091141 °
DWR ID	DWR_NA0017_15_f_2015_140				
Comment Code					
A3 : No rodents visible, but rodent burrows visible; need to backfill and compact or grout burrows.					
Inspector Comment					
This portion of the levee is non-project. Therefore, the rating was given as A/W.

Updated picture of the rodent holes on the landside of the levee. Fall 2016

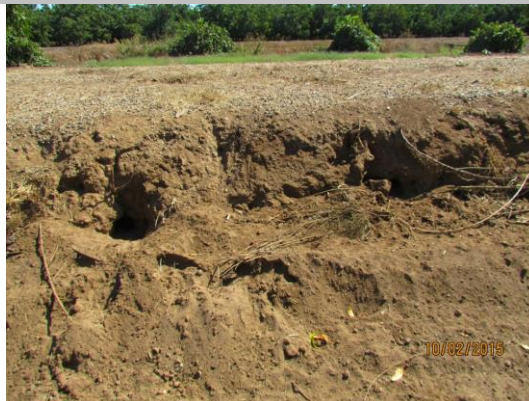
Photo 2 of 2 : FA_2017_NA0017_159_140_20170921_00079.jpg

LM Start	6.67	Rating **	A/W	Issue No.	140 (cont)	
LM End	6.67	Issue Type +	Ma	Location *	LS	
Category	Earthen Levee			GPS Latitude/Longitude		
				Start		End
Item	Animal Control			37.983817 °		37.983817 °
				-121.091141 °		-121.091141 °
DWR ID	DWR_NA0017_15_f_2015_140					
Comment Code						
A3 : No rodents visible, but rodent burrows visible; need to backfill and compact or grout burrows.						
Inspector Comment						
This portion of the levee is non-project. Therefore, the rating was given as A/W.

Rodent holes were found on the landside shoulder of the levee looking downstream.

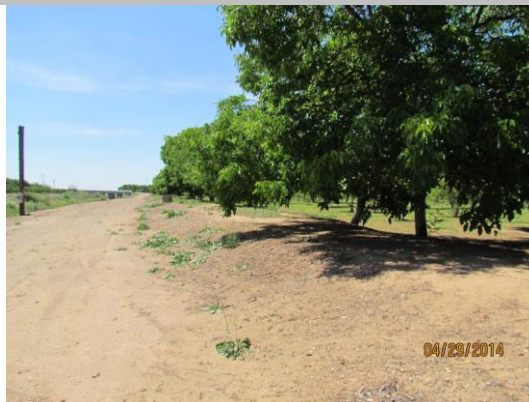
Photo 1 of 1 : FA_2017_NA0017_159_115_20170921_00070.jpg

Tree limbs were obstructing the visibility of the crown of the levee looking downstream.

LM Start	6.96	Rating **	M	Issue No.	115
LM End	7.20	Issue Type +	Ma	Location *	LS
Category	Earthen Levee			GPS Latitude/Longitude	
				Start	End
Item	Trim / Thin Trees			37.981387 °	37.979749 °
				-121.095370 °	-121.099178 °
DWR ID	DWR_NA0017_15_s_2014_115				
Comment Code					
T1 : Trim trees to at least five feet above ground level.					
Inspector Comment					
Trees branches were obstructing the access/patrol road.

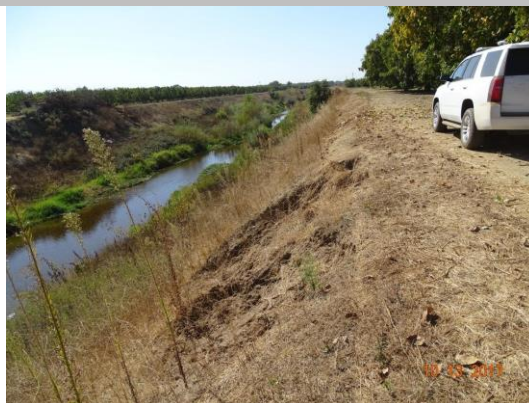
Photo 1 of 1 : FA_2017_NA0017_159_162_20171023_00437.jpg

LM Start	7.67	Rating **	A/W	Issue No.	162
LM End	7.67	Issue Type +	Ma	Location *	LS
Category	Earthen Levee			GPS Latitude/Longitude	
				Start	End
Item	Slope Stability			37.976275 °	37.976275 °
				-121.106364 °	-121.106364 °
DWR ID	DWR_NA0017_15_f_2017_162				
Comment Code					
S1 : Repair slope instability.					
Inspector Comment					
This portion of the levee is non-project. Therefore, the rating was given A/W.

View of slope instability on the waterside slope of the levee looking downstream. Fall 2017

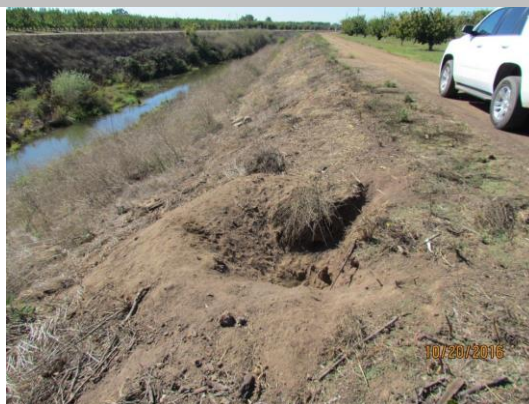
Photo 1 of 1 : FA_2017_NA0017_159_84_20170921_00059.jpg

LM Start	7.73	Rating **	M	Issue No.	84
LM End	7.73	Issue Type +	Ma	Location *	WS
Category	Earthen Levee			GPS Latitude/Longitude	
				Start	End
Item	Animal Control			37.975679 °	37.975679 °
				-121.107246 °	-121.107246 °
DWR ID	DWR_NA0017_15_f_2016_84				
Comment Code					
A3 : No rodents visible, but rodent burrows visible; need to backfill and compact or grout burrows.					
Inspector Comment					
Rodent hole on the shoulder of the waterside of the levee. It might cut into the access road in future.

View of a rodent hole on the waterside of the levee looking downstream. Fall 2016

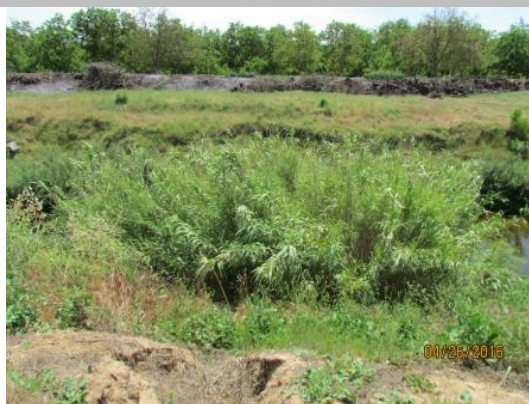
Photo 1 of 1 : FA_2017_NA0017_159_82_20170921_00057.jpg

LM Start	8.39	Rating **	M	Issue No.	82	
LM End	8.39	Issue Type +	Ma	Location *		
Category	Rivers, Channels & Designated Floodways			GPS Latitude/Longitude		
				Start		End
Item	Vegetation & Obstructions			37.969776 °		37.969776 °
				-121.116070 °		-121.116070 °
DWR ID	DWR_NA0017_15_s_2017_82					
Comment Code						
Inspector Comment

View of arundo on the waterside toe of the levee.

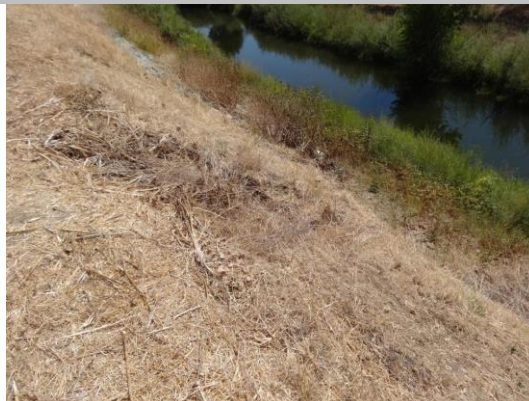
Photo 1 of 3 : SJR2017_NA0017U15RM14.49_1.jpg

LM Start	8.43	Rating **	M	Issue No.	5
LM End	8.43	Issue Type +	Ma	Location *	WS
Category	Supplemental			GPS Latitude/Longitude	
				Start	End
Item	DWR Erosion Survey			37.969711 °	37.969711 °
				-121.116739 °	-121.116739 °
DWR ID	NA0017U15RM14.49				
Comment Code					
Inspector Comment					
08/30/2017: No significant change observed.					
08/16/2016: The erosion was not visible due to dense vegetation at the site.					
08/12/2015: No significant change observed. More vegetation is observed at the site.					
08/20/2014: No significant change observed.					
09/12/2013: The erosion has been caused by runoff. [2017 Site ID:NA0017U15RM14.49]

Looking down at the erosion site from the levee crest. Erosion was covered by dried vegetation.

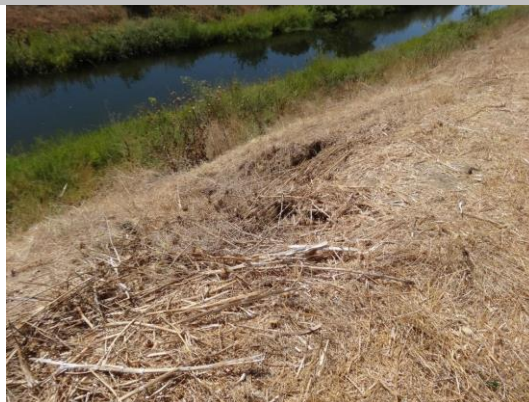
Photo 2 of 3 : SJR2017_NA0017U15RM14.49_2.jpg

Close view of the erosion site covered by dense vegetation.

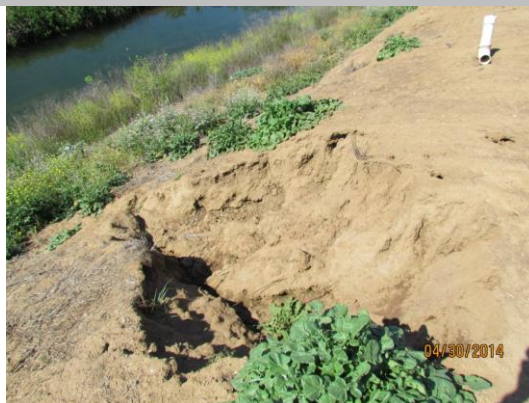
Photo 2 of 2 : FA_2017_NA0017_159_65_20170921_00048.jpg

LM Start	8.43	Rating **	M	Issue No.	65 (cont)	
LM End	8.43	Issue Type +	Ma	Location *		
Category	Rivers, Channels & Designated Floodways			GPS Latitude/Longitude		
				Start		End
Item	Erosion / Bank Caving			37.969699 °		37.969699 °
				-121.116796 °		-121.116796 °
DWR ID	DWR_NA0017_15_s_2017_65					
Comment Code						
Inspector Comment

View of the slope instability on the waterside of the levee looking downstream during spring 2014 inspection.

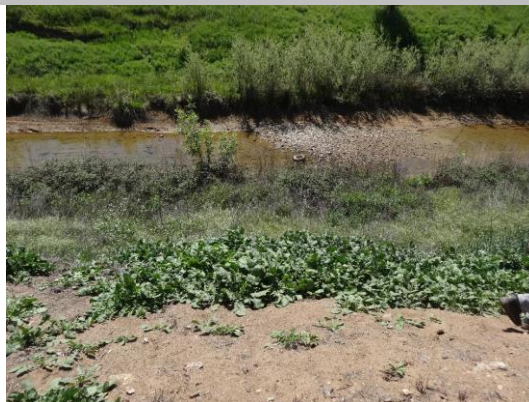
Photo 1 of 3 : UCIP_FA_2017_40386_63765.jpg

LM Start	8.46	Rating **	M	Issue No.	1175
LM End	8.46	Issue Type +	Ma	Location *	
Category	Supplemental			GPS Latitude/Longitude	
				Start	End
Item	DWR UCIP LMA Responsibility			37.969690 °	37.969690 °
				-121.117404 °	-121.117404 °
DWR ID					
Comment Code					
Inspector Comment					
FS_ID:40386 DS_ID:23227 EP_NO: N/A Repair Type: Non-Urgent Crossing Status: Found UCIP Comments: Distorted inlet pipe opening on landside. No pipe found on waterside. Dense vegetation and steep slope on waterside. FIELD_STRUCT_DESC: 18-inch CM pipe through the levee, 1.0 feet below the crown. O&M Manual SJR Assumed 999. FS Date: 4/10/2014

WS view: no pipe or appurtenances found on waterside. Dense vegetation.

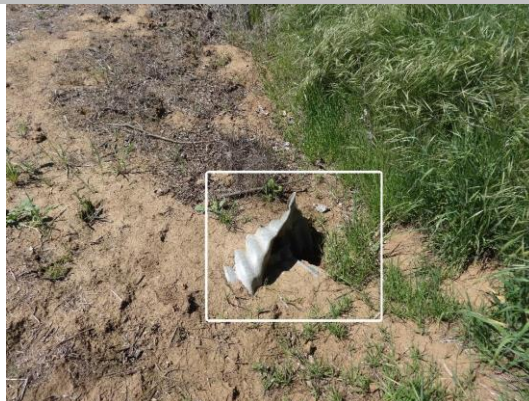
Photo 2 of 3 : UCIP_FA_2017_40386_63764.jpg

FS_ID:40386
DS_ID:23227
EP_NO: N/A
Repair Type: Non-Urgent
Crossing Status: Found
UCIP Comments: Distorted inlet pipe opening on landside. No pipe found on waterside. Dense vegetation and steep slope on waterside.
FIELD_STRUCT_DESC: 18-inch CM pipe through the levee, 1.0 feet below the crown. O&M Manual SJR Assumed 999.
FS Date: 4/10/2014

LS view: distorted CM outlet pipe on levee slope.

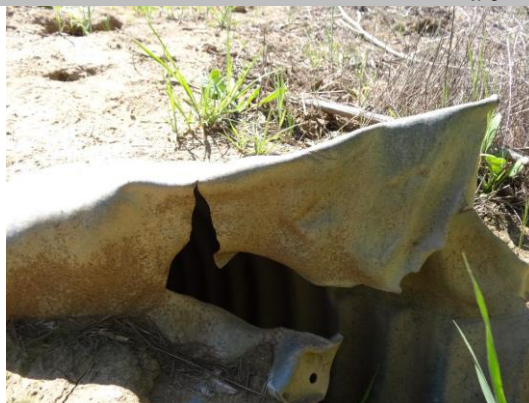
Photo 3 of 3 : UCIP_FA_2017_40386_63763.jpg

LS view: closer view of distorted CM outlet pipe on levee slope.

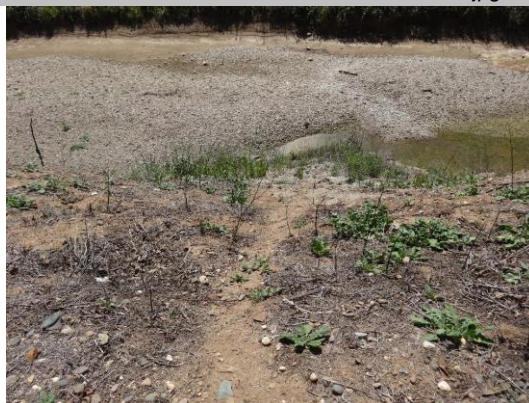
Photo 1 of 2 : UCIP_FA_2017_40387_62949.jpg

Comment Code						
Inspector Comment						
FS_ID:40387						
DS_ID:23229						
EP_NO: N/A						
Repair Type: Non-Urgent						
Crossing Status: Found						
UCIP Comments: Distorted pipe opening on landside. Inlet pipe needs clearing and cleaning.No pipe visible on waterside.						
FIELD_STRUCT_DESC: 18-inch corrugated metal drainage pipe and electrical conduit of an unknown material through the levee, 1 foot below the crown. Power pole on the landside (LS). Electrical conduit through the levee. Outlet of pipe rock revetted. [Additional Reference(s): DWR Levee Log, 1992. USACE San Joaquin O&M Manual 611.1, Volume F, (HLM 8.88)].						
FS Date: 4/10/2014

WS view: no pipe or appurtenances found. Steep levee slope.

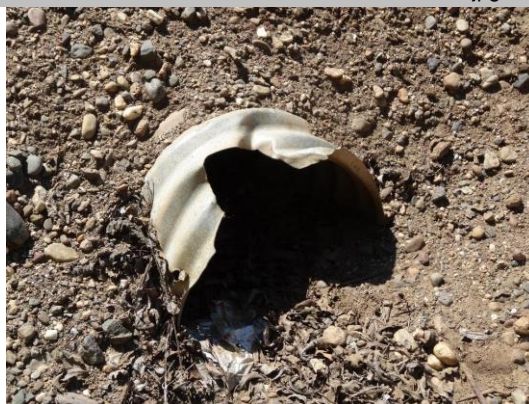
Photo 2 of 2 : UCIP_FA_2017_40387_62948.jpg

LS view: distorted CM inlet pipe. Partially buried.

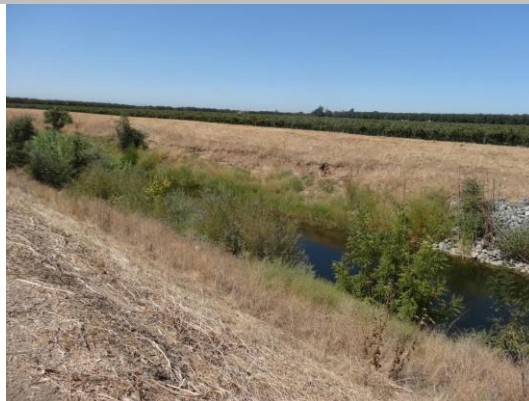
Photo 1 of 4 : SJR2017_NA0017U15RM13.87_1.jpg

LM Start	8.81	Rating **	M	Issue No.	4
LM End	8.83	Issue Type +	Ma	Location *	WS
Category	Supplemental			GPS Latitude/Longitude	
				Start	End
Item	DWR Erosion Survey			37.968060 °	37.968060 °
				-121.123299 °	-121.123299 °
DWR ID	NA0017U15RM13.87				
Comment Code					
Inspector Comment					
08/30/2017: No significant change observed.					
08/16/2016: No significant change observed.					
08/12/2015: No significant change observed.					
08/20/2014: Both ends of the erosion site are protected by riprap. [2017					
Site ID:NA0017U15RM13.87]

View of the site from left river bank.

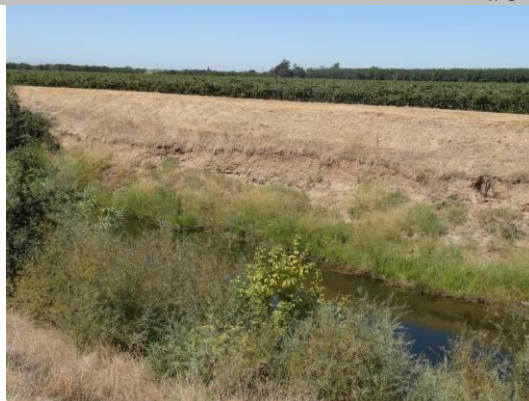
Photo 2 of 4 : SJR2017_NA0017U15RM13.87_2.jpg

Close view of the erosion.

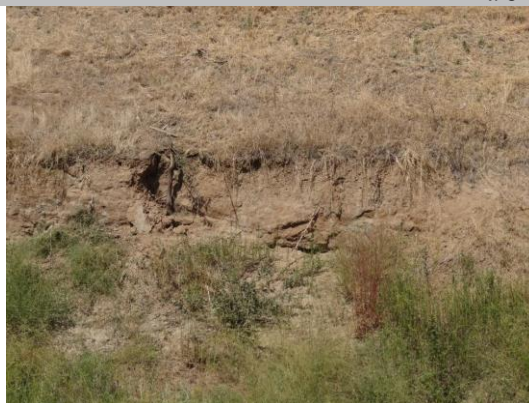
Photo 3 of 4 : SJR2017_NA0017U15RM13.87_3.jpg

Close view of the erosion.

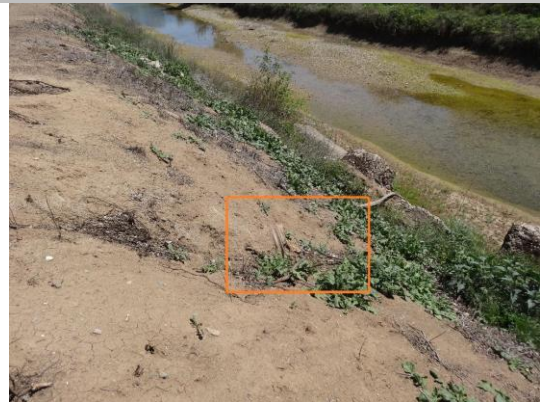
Photo 1 of 3 : UCIP_FA_2017_34983_62966.jpg

LM Start	9.55	Rating **	M	Issue No.	1178
LM End	9.55	Issue Type +	Ma	Location *	
Category	Supplemental			GPS Latitude/Longitude	
				Start	End
Item	DWR UCIP LMA Responsibility			37.966327 °	37.966327 °
				-121.135980 °	-121.135980 °
DWR ID					
Comment Code					
Inspector Comment					
FS_ID:34983					
DS_ID:23233					
EP_NO: N/A					
Repair Type: Non-Urgent					
Crossing Status: Found					
UCIP Comments: Needs clearing and cleaning of the pipe.					
FIELD_STRUCT_DESC: 18-inch corrugated metal drainage pipe through the levee, 3.5 feet below the crown. Pipe discharges onto waterside (WS) slope. Slope eroding. [Additional Reference(s): DWR Levee Log, 1992. USACE San Joaquin O&M Manual 611.1, Volume F, (HLM 9.75)].					
FS Date: 4/10/2014

WS view: CM outlet pipe on levee slope.

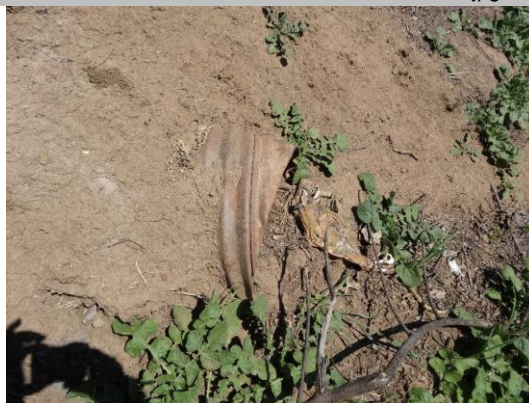
Photo 2 of 3 : UCIP_FA_2017_34983_62965.jpg

WS view: CM outlet pipe on levee slope.

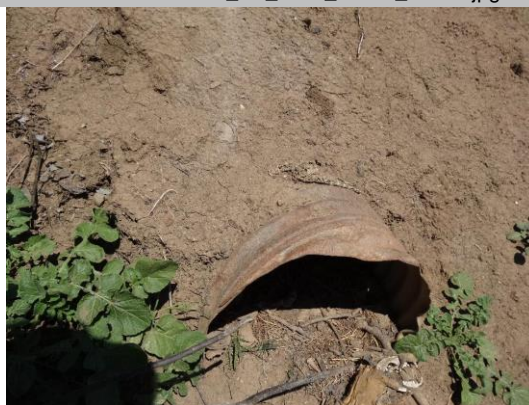
Photo 3 of 3 : UCIP_FA_2017_34983_62964.jpg

WS view: closer view of CM outlet pipe on levee slope.

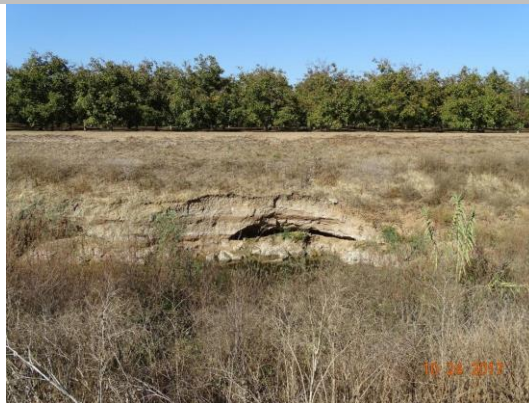
Photo 1 of 1 : FA_2017_NA0017_159_183_20171027_00547.jpg

LM Start	9.62	Rating **	A/W	Issue No.	183
LM End	9.62	Issue Type +	Ma	Location *	WS
Category	Earthen Levee			GPS Latitude/Longitude	
				Start	End
Item	Erosion / Bank Caving			37.965693 °	37.965693 °
				-121.137063 °	-121.137063 °
DWR ID	DWR_NA0017_15_f_2017_183				
Comment Code					
E1 : Note and monitor erosion site.					
Inspector Comment					
Erosion was found on the waterside toe of the levee. It possibly could be a beaver den at this location.

View of an erosion with a possible beaver den on the waterside toe of the levee. The picture was taken from the opposite side of the levee. Fall 2017

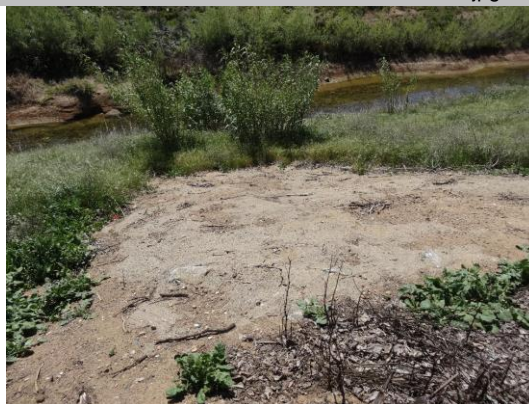
Photo 1 of 3 : UCIP_FA_2017_34986_62986.jpg

LM Start	9.80	Rating **	M	Issue No.	1181
LM End	9.80	Issue Type +	Ma	Location *	
Category	Supplemental			GPS Latitude/Longitude	
				Start	End
Item	DWR UCIP LMA Responsibility			37.965294 °	37.965294 °
				-121.140184 °	-121.140184 °
DWR ID					
Comment Code					
Inspector Comment					
FS_ID:34986					
DS_ID:23235					
EP_NO: N/A					
Repair Type: Non-Urgent					
Crossing Status: Found					
UCIP Comments: Mud/soil in inlet pipe. Needs cleaning.No pipe or appurtenances visible on waterside. Dense vegetation (may be visible from other channel bank).					
FIELD_STRUCT_DESC: 18-inch corrugated metal drainage pipe through the levee, 4 feet below the crown. Grouted inlet and outlet.					
[Additional Reference(s): DWR Levee Log, 1992. USACE San Joaquin O&M Manual 611.1, Volume F, (HLM 10.01)].					
FS Date: 4/10/2014

WS view: no pipe or appurtenances found.

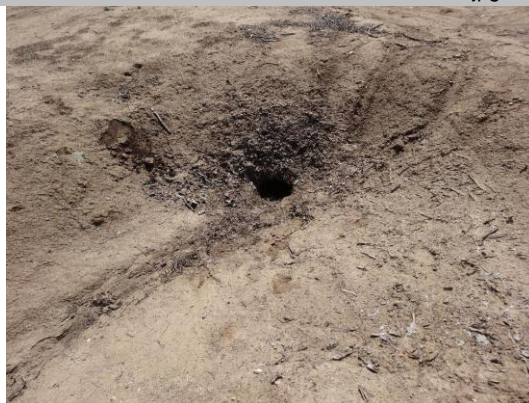
Photo 2 of 3 : UCIP_FA_2017_34986_62985.jpg

LS view: partially buried inlet pipe.

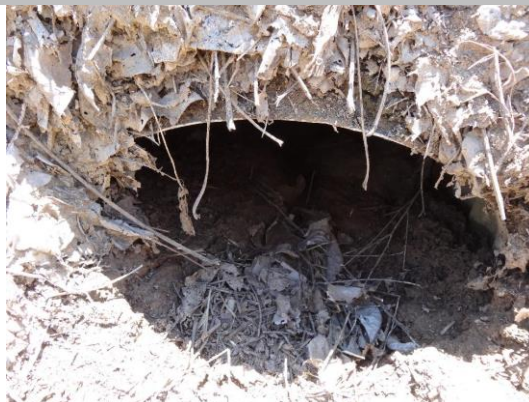
Photo 3 of 3 : UCIP_FA_2017_34986_62984.jpg

LS view: closer view of partially buried inlet pipe. Needs cleaning and clearing.

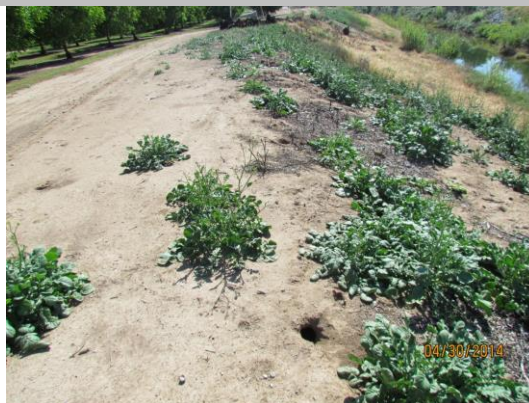
Photo 1 of 1 : FA_2017_NA0017_159_126_20170921_00074.jpg

LM Start	9.83	Rating **	A/W	Issue No.	126
LM End	9.83	Issue Type +	Ma	Location *	WS
Category	Earthen Levee			GPS Latitude/Longitude	
				Start	End
Item	Animal Control			37.965343 °	37.965343 °
				-121.140761 °	-121.140761 °
DWR ID	DWR_NA0017_15_s_2014_126				
Comment Code					
A3 : No rodents visible, but rodent burrows visible; need to backfill and compact or grout burrows.					
Inspector Comment					
This portion of the levee is non-project. Therefore, the rating was given as A/W.

View of rodent holes on the waterside of the levee looking upstream.

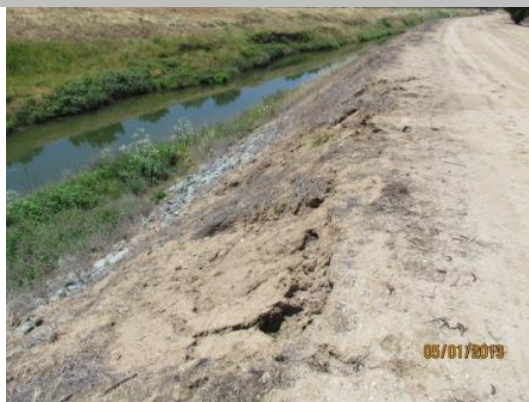
Photo 1 of 1 : FA_2017_NA0017_159_68_20170921_00051.jpg

LM Start	9.90	Rating **	A/W	Issue No.	68
LM End	9.90	Issue Type +	Ma	Location *	WS
Category	Earthen Levee			GPS Latitude/Longitude	
				Start	End
Item	Slope Stability			37.965165 °	37.965165 °
				-121.141928 °	-121.141928 °
DWR ID	DWR_NA0017_15_s_2013_68				
Comment Code					
S1 : Repair slope instability.					
Inspector Comment					
This portion of the levee is non-project. Therefore, the rating was given as A/W.

Slope instability was found on the waterside slope of the levee looking downstream.

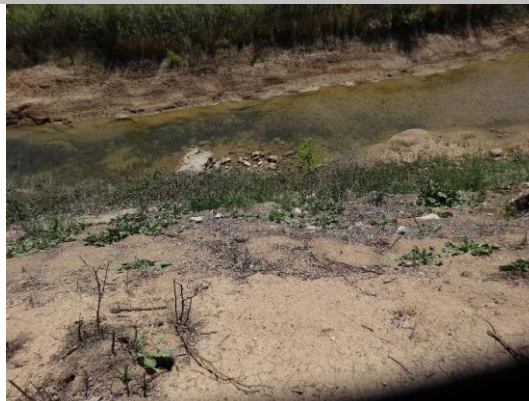
Photo 1 of 3 : UCIP_FA_2017_34987_62992.jpg

LM Start	10.01	Rating **	M	Issue No.	1182	
LM End	10.01	Issue Type +	Ma	Location *		
Category	Supplemental			GPS Latitude/Longitude		
				Start	End	
Item	DWR UCIP LMA Responsibility			37.965085 °	37.965085 °	
				-121.143999 °	-121.143999 °	
DWR ID						
Comment Code						
Inspector Comment						
FS_ID:34987						
DS_ID:23236						
EP_NO: N/A						
Repair Type: Non-Urgent						
Crossing Status: Found						
UCIP Comments: May need cleaning of the pipe.Pipe not visible on waterside.						
FIELD_STRUCT_DESC: 18-inch corrugated metal drainage pipe through the levee, 4.5 feet below the crown. Grouted inlet and outlet.						
[Additional Reference(s): DWR Levee Log, 1992. USACE San Joaquin O&M Manual 611.1, Volume F, (HLM 10.22)].						
FS Date: 4/10/2014

WS view: no pipe or appurtenances found.

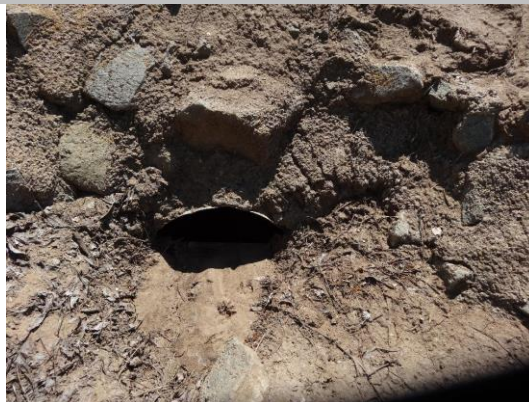
Photo 2 of 3 : UCIP_FA_2017_34987_62990.jpg

LS view: partially buried inlet pipe on levee toe.

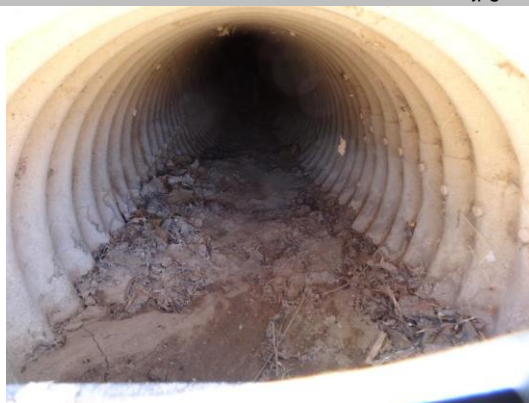
Photo 3 of 3 : UCIP_FA_2017_34987_62991.jpg

LS view: inside view of partially buried inlet pipe. Needs cleaning.

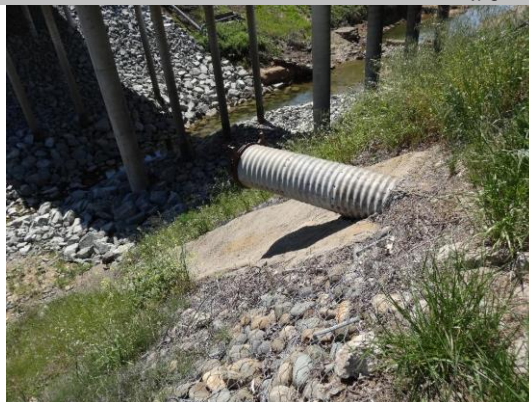
Photo 1 of 2 : UCIP_FA_2017_35003_63003.jpg

LM Start	10.26	Rating **	A/W	Issue No.	1183
LM End	10.26	Issue Type +	Ma	Location *	
Category	Supplemental			GPS Latitude/Longitude	
				Start	End
Item	DWR UCIP LMA Responsibility			37.965104 °	37.965104 °
				-121.148460 °	-121.148460 °
DWR ID					
Comment Code					
Inspector Comment					
FS_ID:35003					
DS_ID:23237					
EP_NO: N/A					
Repair Type: No Action Needed					
Crossing Status: Found					
UCIP Comments: May need cleaning of the inlet pipe. Vegetation debris on inlet box.					
FIELD_STRUCT_DESC: 18-inch corrugated metal drainage pipe through the levee, 7.5 feet below the crown. Concrete U-shaped headwall on the landside (LS). Flap gate on the waterside (WS). [Additional Reference(s): DWR Levee Log, 1992. USACE San Joaquin O&M Manual 611.1, Volume F, (HLM 10.47)].					
FS Date: 4/10/2014

WS view: CM outfall pipe with flapgate on levee slope.

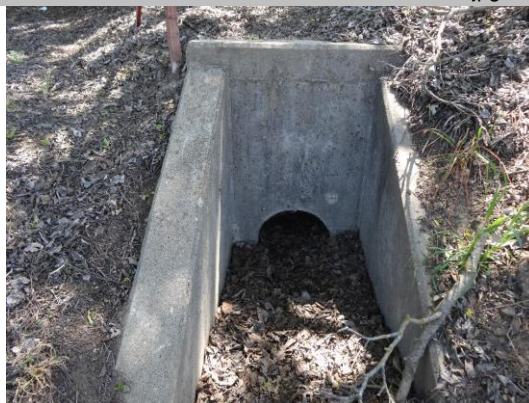
Photo 2 of 2 : UCIP_FA_2017_35003_63002.jpg

LS view: concrete headwall and inlet pipe. Needs cleaning of debris.

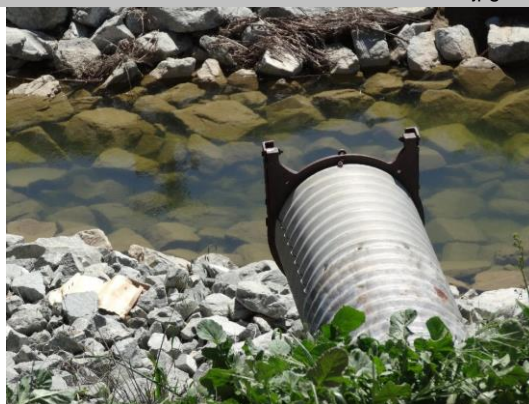
Photo 1 of 2 : UCIP_FA_2017_35005_63011.jpg

LM Start	10.27	Rating **	M	Issue No.	1185	
LM End	10.27	Issue Type +	Ma	Location *		
Category	Supplemental			GPS Latitude/Longitude		
				Start	End	
Item	DWR UCIP LMA Responsibility			37.965097 °	37.965097 °	
				-121.148671 °	-121.148671 °	
DWR ID						
Comment Code						
Inspector Comment						
FS_ID:35005						
DS_ID:23238						
EP_NO: N/A						
Repair Type: Non-Urgent						
Crossing Status: Found						
UCIP Comments: Pipe buried on landside. May need cleaning of vegetation debris in inlet opening.						
FIELD_STRUCT_DESC: 18-inch corrugated metal drainage pipe through the levee, 7.5 feet below the crown. Flap gate on the waterside (WS). [Additional Reference(s): DWR Levee Log, 1992. USACE San Joaquin O&M Manual 611.1, Volume F, (HLM 10.49)].						
FS Date: 4/10/2014

WS view: CM outfall pipe with flapgate on levee slope.

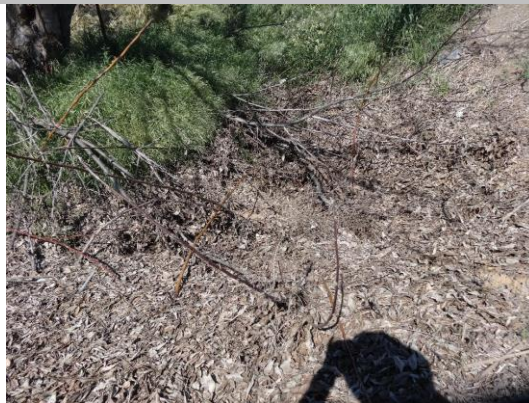
Photo 2 of 2 : UCIP_FA_2017_35005_63010.jpg

LS view: vegetation debris in inlet area. Needs cleaning and clearing.

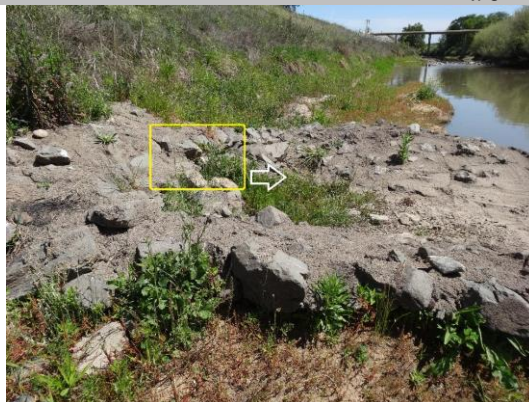
Photo 1 of 2 : UCIP_FA_2017_35010_63035.jpg

LM Start	11.41	Rating **	M	Issue No.	1187	
LM End	11.41	Issue Type +	Ma	Location *		
Category	Supplemental			GPS Latitude/Longitude		
				Start	End	
Item	DWR UCIP LMA Responsibility			37.960784 °	37.960784 °	
				-121.168119 °	-121.168119 °	
DWR ID						
Comment Code						
Inspector Comment						
FS_ID:35010 DS_ID:23243 EP_NO: N/A Repair Type: Non-Urgent Crossing Status: Found UCIP Comments: Distorted outlet pipe on waterside. FIELD_STRUCT_DESC: 18-inch corrugated metal drainage pipe, 4 feet below the roadway. Grouted outlet on the waterside (WS). [Additional Reference(s): DWR Levee Log, 1992. USACE San Joaquin O&M Manual 611.1, Volume F, (HLM 11.64)]. FS Date: 4/14/2014

WS view: outlet pipe on grouted riprap on levee slope.

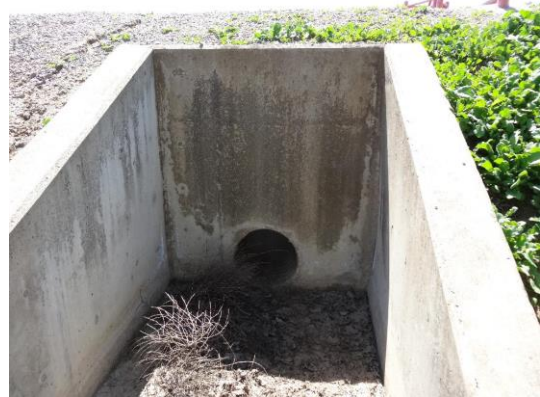
Photo 2 of 2 : UCIP_FA_2017_35010_63034.jpg

LS view: headwall and inlet pipe on levee toe.

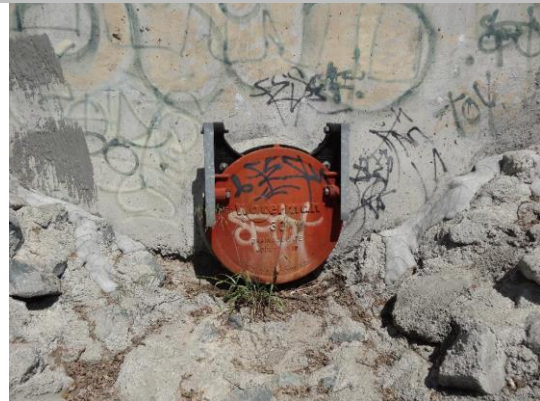
Photo 1 of 2 : UCIP_FA_2017_48304_63039.jpg

LM Start	11.55	Rating **	A/W	Issue No.	1188	
LM End	11.55	Issue Type +	Ma	Location *		
Category	Supplemental			GPS Latitude/Longitude		
				Start		End
Item	DWR UCIP LMA Responsibility			37.960961 °	37.960961 °	
				-121.170662 °	-121.170662 °	
DWR ID						
Comment Code						
Inspector Comment						
FS_ID:48304						
DS_ID:23244						
EP_NO: N/A						
Repair Type: No Action Needed						
Crossing Status: Found						
UCIP Comments: New pipe and flapgate.						
FIELD_STRUCT_DESC: 30-inch corrugated metal drainage pipe through the levee, 4.5 feet below the crown. Flap gate on the waterside (WS). Headwall with open inlet pipe on the landside (LS). Grouted outlet. [Additional Reference(s): DWR Levee Log, 1992, 18-inch pipe listed. USACE San Joaquin O&M Manual 611.1, Volume F, (HLM 11.79) 18-inch pipe listed].						
FS Date: 4/14/2014

WS view: outlet CM pipe with flapgate. Flood wall acts as headwall.

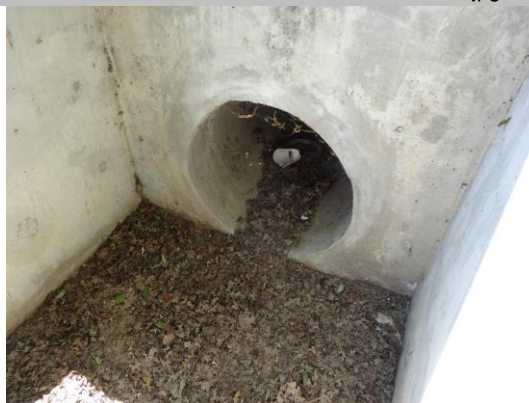
Photo 2 of 2 : UCIP_FA_2017_48304_63038.jpg

LS view: inlet pipe and headwall on levee toe. May need cleaning of inlet opening.

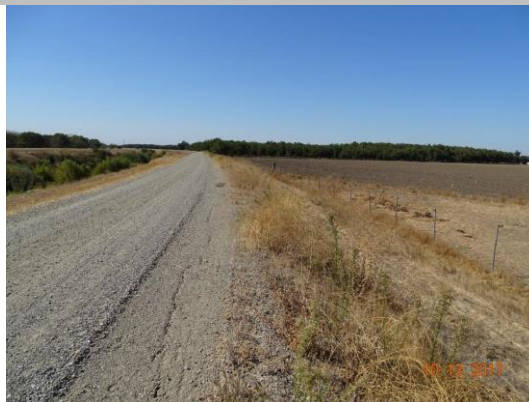
Photo 1 of 1 : FA_2017_NA0017_159_164_20171023_00438.jpg

LM Start	11.63	Rating **	M	Issue No.	164
LM End	13.18	Issue Type +	Ma	Location *	LS
Category	Earthen Levee			GPS Latitude/Longitude	
				Start	End
Item	Vegetation			37.961383 °	37.961103 °
				-121.172181 °	-121.199605 °
DWR ID	DWR_NA0017_15_f_2017_164				
Comment Code					
V1 : Control annual grass and weeds on the levee slopes and easements.					
Inspector Comment

View of vegetation on the landside of the levee. Fall 2017

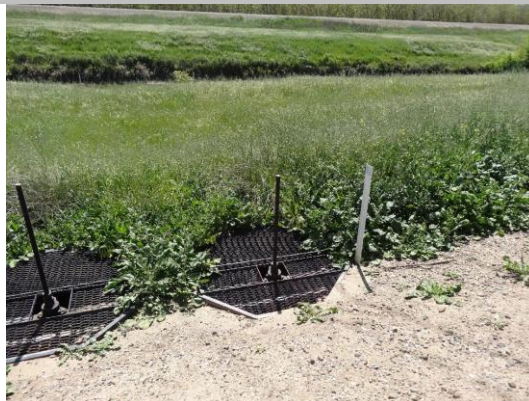
Photo 1 of 3 : UCIP_FA_2017_35014_63053.jpg

WS view: slide gates in CMP risers on levee slope.

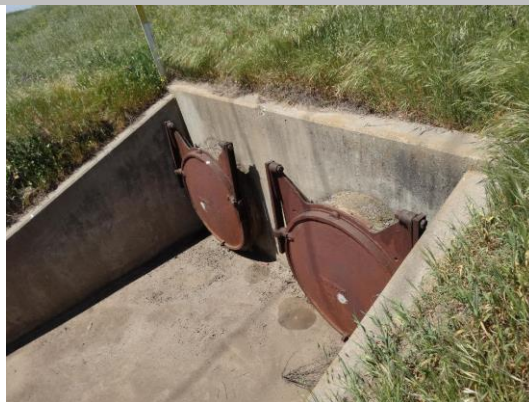
Photo 2 of 3 : UCIP_FA_2017_35014_63052.jpg

WS view: flap gates and headwall on levee slope.

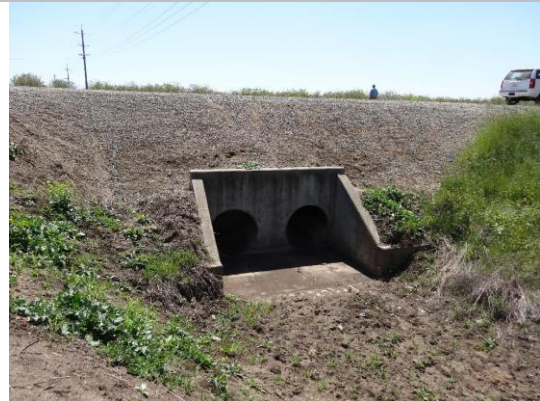
Photo 3 of 3 : UCIP_FA_2017_35014_63051.jpg

LS view: headwall and inlet pipes on levee slopes.

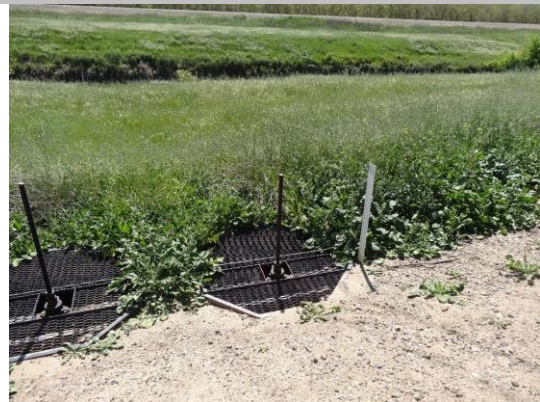
Photo 1 of 3 : UCIP_FA_2017_35015_63059.jpg

WS view: slide gates in CMP risers on levee slope.

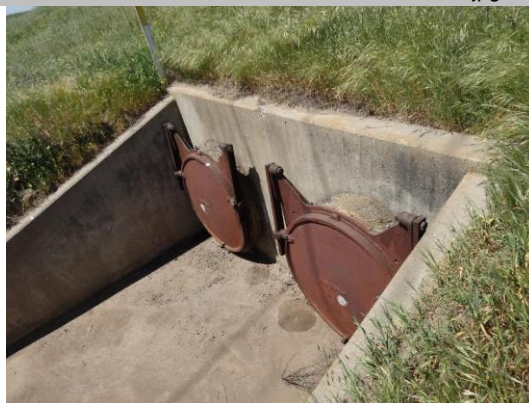
Photo 2 of 3 : UCIP_FA_2017_35015_63058.jpg

WS view: headwall and flap gates on CMP ends on levee slope.

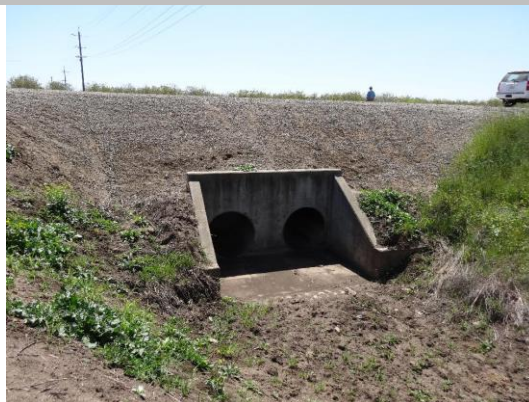
Photo 3 of 3 : UCIP_FA_2017_35015_63057.jpg

LS view: headwall and inlet pipes on levee slope.

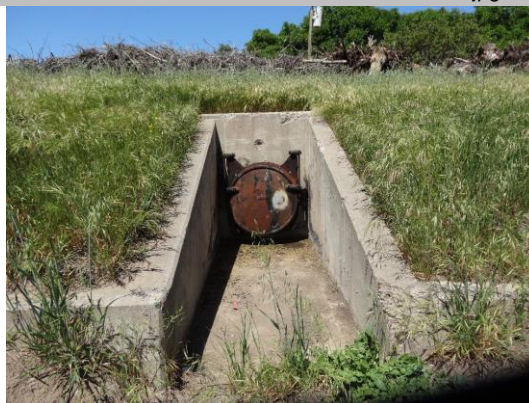
Photo 1 of 3 : UCIP_FA_2017_35043_63085.jpg

WS view: U type concrete headwall, CM pipe with flapgate, and concrete spillway on levee slope.
