**Flood Control Project Maintenance
Levee Inspections**

Maintenance Issue Types Only, Levee Inspection Report By Mile - Fall 2017

San Joaquin County Flood Control and Water Conservation District

Waterway	Bank	Unit Miles	Inspection Start/End	Inspector
Unit No. 01 Littlejohn Creek	Left	2.59	10/17/2017 10/17/2017	Pavel Kazi

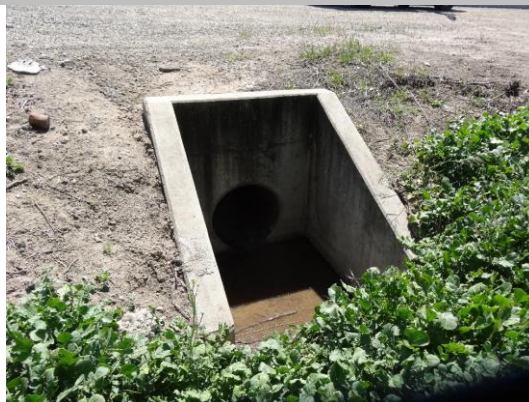
Photo 2 of 3 : UCIP_FA_2017_35043_63084.jpg

LS view: U type concrete headwall and CM inlet Pipe on levee slope.
Soil/mud on inlet box.

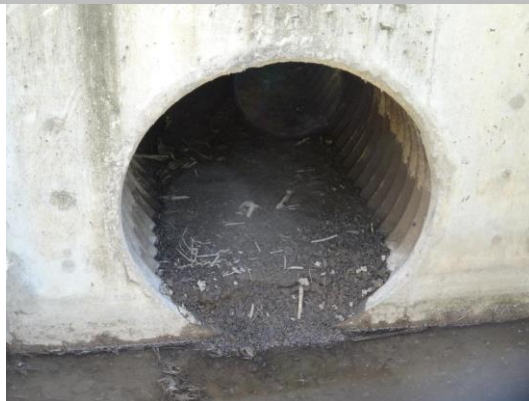
Photo 3 of 3 : UCIP_FA_2017_35043_63083.jpg

LS view: inside view of the CM pipe. Needs cleaning and clearing the pipe.

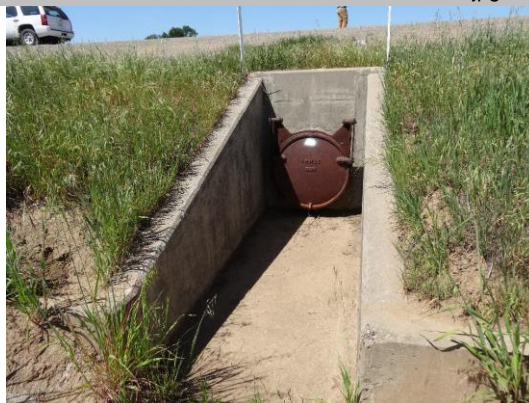
Photo 1 of 3 : UCIP_FA_2017_35047_63100.jpg

WS view: U type concrete headwall, CM pipe with flapgate, and concrete spillway on levee slope.

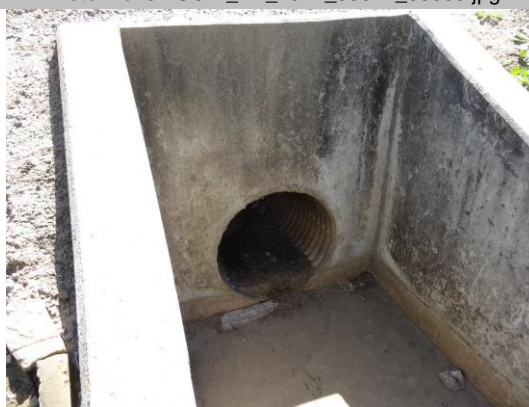
Photo 2 of 3 : UCIP_FA_2017_35047_63099.jpg

LS view: U type concrete headwall and CM inlet Pipe on levee slope. Soil/mud on inlet box.

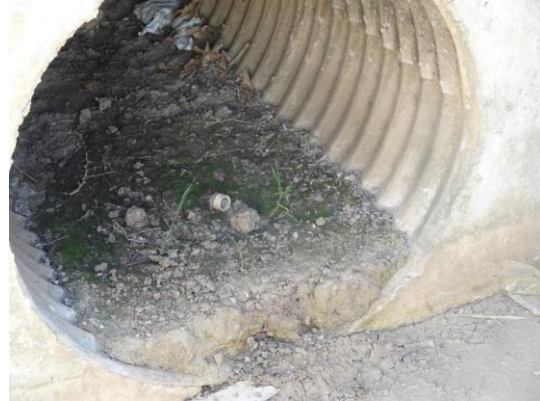
Photo 3 of 3 : UCIP_FA_2017_35047_63101.jpg

LS view: inside view of the CM pipe. Needs cleaning and clearing the pipe.

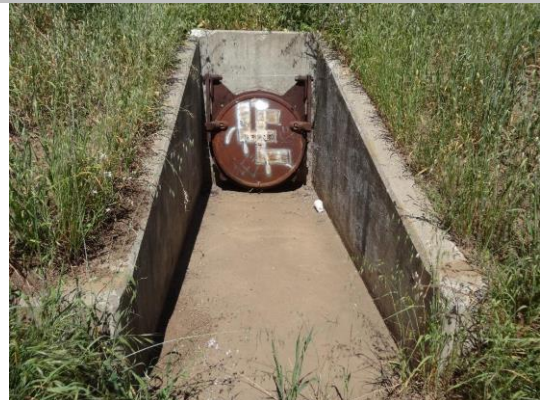
Photo 1 of 3 : UCIP_FA_2017_35049_63113.jpg

WS view: U type concrete headwall, CM pipe with flapgate, and concrete spillway on levee slope.

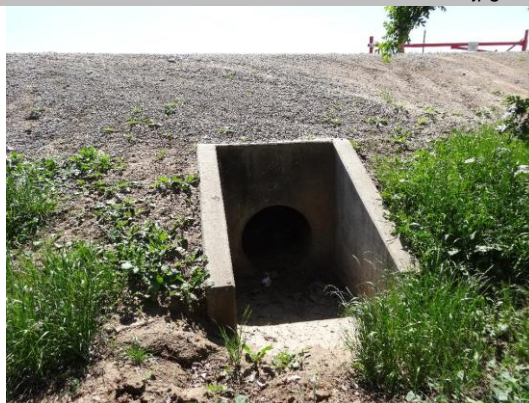
Photo 2 of 3 : UCIP_FA_2017_35049_63112.jpg

LS view: U type concrete headwall and CM inlet Pipe on levee slope.
Soil/mud on inlet box.

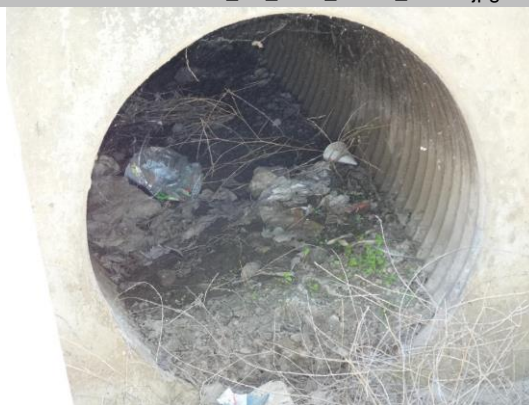
Photo 3 of 3 : UCIP_FA_2017_35049_63111.jpg

LS view: inside view of the CM pipe. Needs cleaning and clearing the pipe.

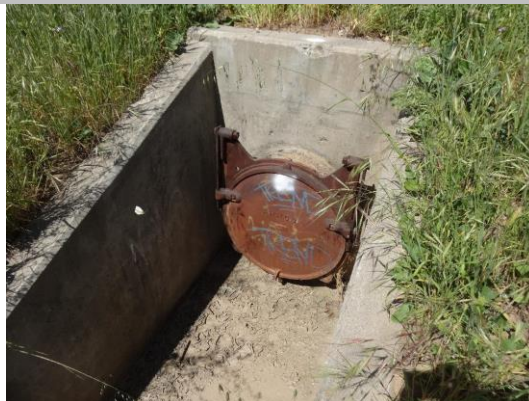
Photo 1 of 3 : UCIP_FA_2017_35064_63131.jpg

WS view: U type concrete headwall, CM pipe with flapgate, and concrete spillway on levee slope.

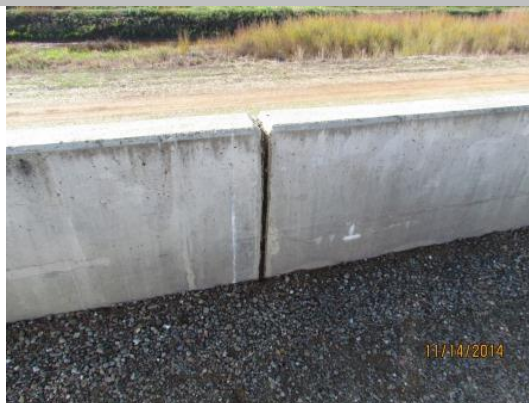
Photo 1 of 1 : FA_2017_NA0017_159_180_20170921_00093.jpg

LM Start	15.04	Rating **	M	Issue No.	180
LM End	15.04	Issue Type +	Ma	Location *	WS
Category	Concrete Floodwalls			GPS Latitude/Longitude	
				Start	End
Item	Monolith Joints			37.973416 °	37.973416 °
				-121.228922 °	-121.228922 °
DWR ID	DWR_NA0017_15_f_2014_180				
Comment Code					
Inspector Comment

The monolith joint is deteriorating on the waterside shoulder of the levee.

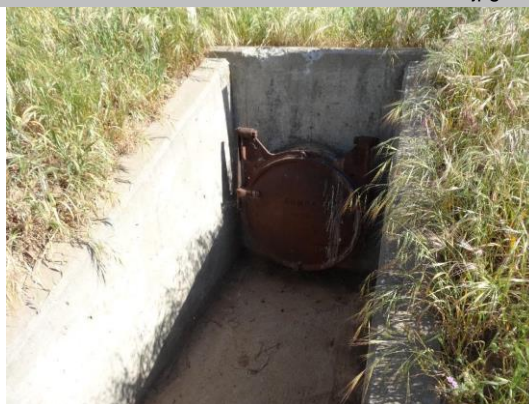
Photo 1 of 3 : UCIP_FA_2017_35104_63192.jpg

WS view: U type concrete headwall, CM pipe with flapgate, and concrete spillway on levee slope.

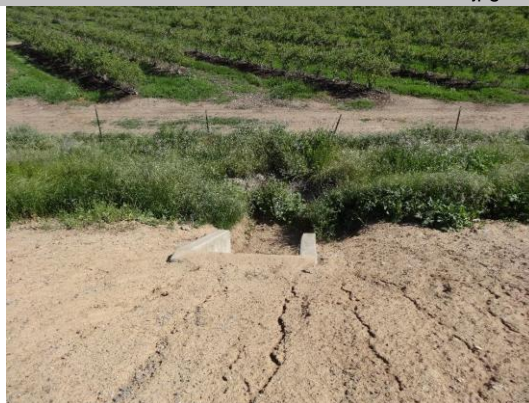
Photo 2 of 3 : UCIP_FA_2017_35104_63191.jpg

LS view: U type concrete headwall on levee slope.

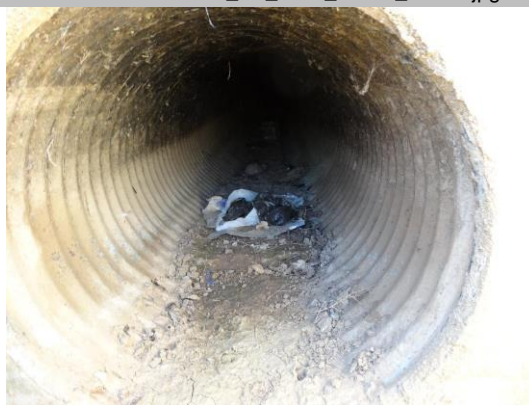
Photo 3 of 3 : UCIP_FA_2017_35104_63193.jpg

LS view: inside view of CM inlet pipe on levee slope. Debris on inlet pipe. Needs cleaning.

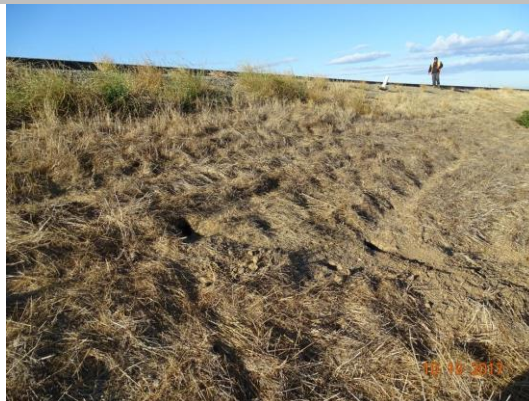
Photo 1 of 1 : FA_2017_NA0017_159_154_20171023_00440.jpg

LM Start	15.37	Rating **	M	Issue No.	154
LM End	15.37	Issue Type +	Ma	Location *	LS
Category	Earthen Levee			GPS Latitude/Longitude	
				Start	End
Item	Animal Control			37.975671 °	37.975671 °
				-121.234277 °	-121.234277 °
DWR ID	DWR_NA0017_15_f_2015_154				
Comment Code					
A3 : No rodents visible, but rodent burrows visible; need to backfill and compact or grout burrows.					
Inspector Comment

View of rodent holes on the landside of the levee. Fall 2017

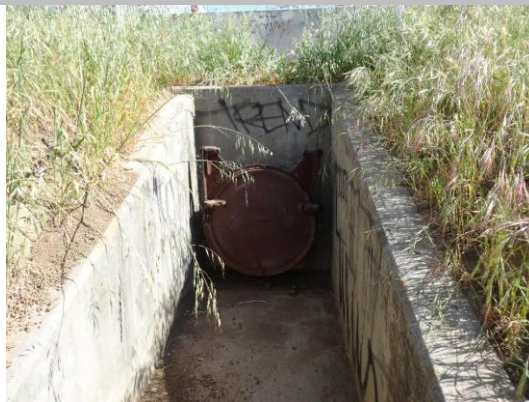
Photo 1 of 2 : UCIP_FA_2017_35105_63197.jpg

WS view: U type concrete headwall, CM pipe with flapgate, and concrete spillway on levee slope.

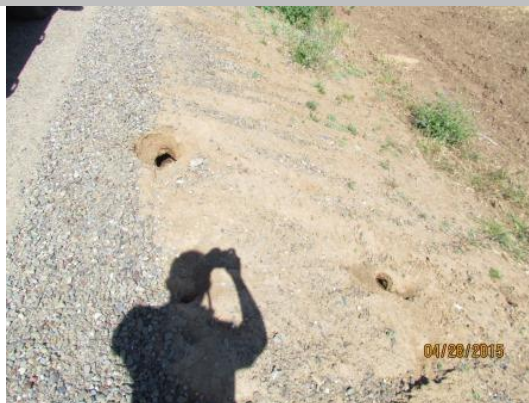
Photo 2 of 2 : FA_2017_NA0017_159_194_20170921_00100.jpg

LM Start	15.41	Rating **	M	Issue No.	194 (cont)	
LM End	15.41	Issue Type +	Ma	Location *	LS	
Category	Earthen Levee			GPS Latitude/Longitude		
				Start		End
Item	Animal Control			37.975893 °		37.975893 °
				-121.234858 °		-121.234858 °
DWR ID	DWR_NA0017_15_s_2015_194					
Comment Code						
A3 : No rodents visible, but rodent burrows visible; need to backfill and compact or grout burrows.						
Inspector Comment

Rodent holes were found on the landside of the levee looking downstream.

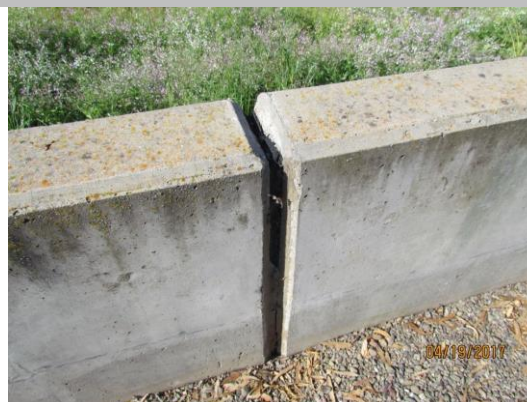
Photo 1 of 1 : FA_2017_NA0017_159_228_20170921_00115.jpg

LM Start	15.55	Rating **	M	Issue No.	228
LM End	15.55	Issue Type +	Ma	Location *	WS
Category	Concrete Floodwalls			GPS Latitude/Longitude	
				Start	End
Item	Monolith Joints			37.976804 °	37.976804 °
				-121.237076 °	-121.237076 °
DWR ID	DWR_NA0017_15_s_2017_228				
Comment Code					
Inspector Comment					
There are multiple monolith joint deteriorations on the flood wall at this section.

View of a deteriorated monolith joint on the flood wall at waterside shoulder of the levee.

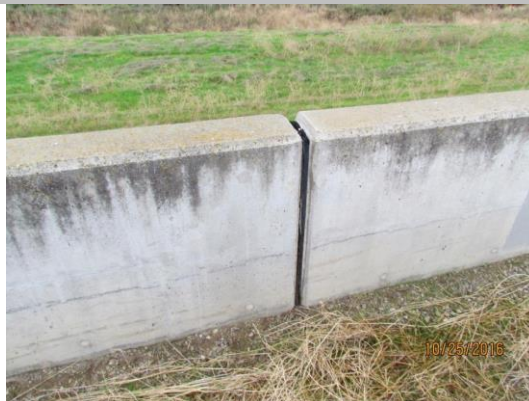
Photo 1 of 1 : FA_2017_NA0017_159_197_20170921_00101.jpg

LM Start	16.26	Rating **	M	Issue No.	197
LM End	16.26	Issue Type +	Ma	Location *	WS
Category	Concrete Floodwalls			GPS Latitude/Longitude	
				Start	End
Item	Monolith Joints			37.981770 °	37.981770 °
				-121.248521 °	-121.248521 °
DWR ID	DWR_NA0017_15_s_2015_197				
Comment Code					
Inspector Comment					
The monolith joint material is deteriorating at this location of the flood wall.

View of deteriorated monolith joint on the waterside shoulder of the levee. Fall 2016

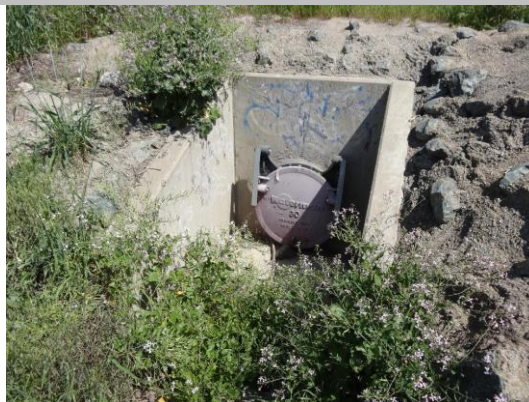
Photo 1 of 3 : UCIP_FA_2017_35128_63241.jpg

WS view: U type concrete headwall, CM pipe with flapgate, and grouted riprap spillway on levee slope.

FS_ID:35128
DS_ID:23194
EP_NO: 7811
Repair Type: No Action Needed
Crossing Status: Found
UCIP Comments: May need cleaning.
FIELD_STRUCT_DESC: 30-inch corrugated metal drainage pipe through the levee, 10 feet below the crown. Concrete U-shaped headwalls on both ends. Grouted spillway and inlet. Flap gate on the waterside (WS) end. (Permit No. 7811-A, 1975 - Linzo Bozzano).
[Additional Reference(s): DWR Levee Log, 1992. USACE San Joaquin O&M Manual 611.1, Volume F, (HLM 16.83)].
FS Date: 4/15/2014

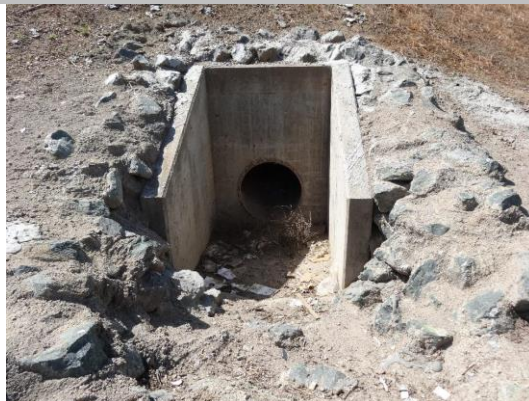
Photo 2 of 3 : UCIP_FA_2017_35128_63240.jpg

LS view: U type concrete headwall and CM pipe on levee slope. Debris in inlet pipe.

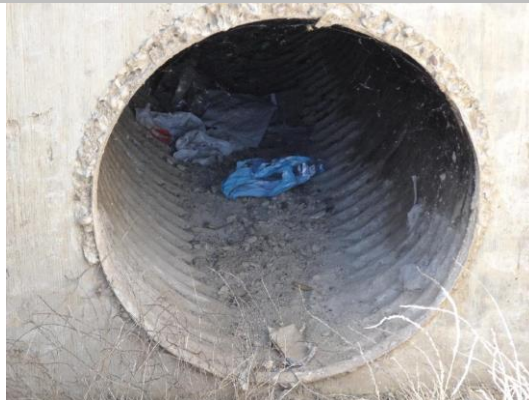
Photo 3 of 3 : UCIP_FA_2017_35128_63239.jpg

LS view: inside view of the CM pipe. Needs cleaning and clearing the pipe.

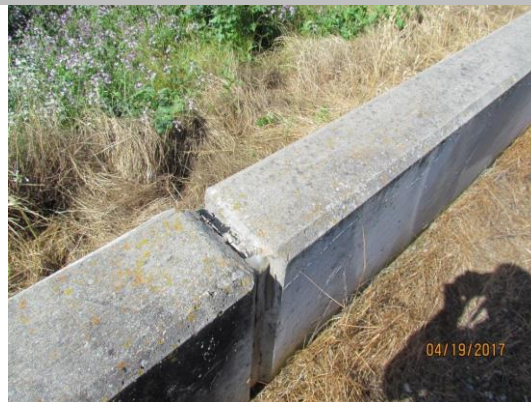
Photo 1 of 1 : FA_2017_NA0017_159_236_20170921_00116.jpg

LM Start	16.73	Rating **	M	Issue No.	236
LM End	16.73	Issue Type +	Ma	Location *	WS
Category	Concrete Floodwalls			GPS Latitude/Longitude	
				Start	End
Item	Monolith Joints			37.984922 °	37.984922 °
				-121.256014 °	-121.256014 °
DWR ID	DWR_NA0017_15_s_2017_236				
Comment Code					
Inspector Comment					
There are multiple monolith joint deteriorations on the flood wall at this section.

View of a deteriorated monolith joint on the flood wall at waterside shoulder of the levee.

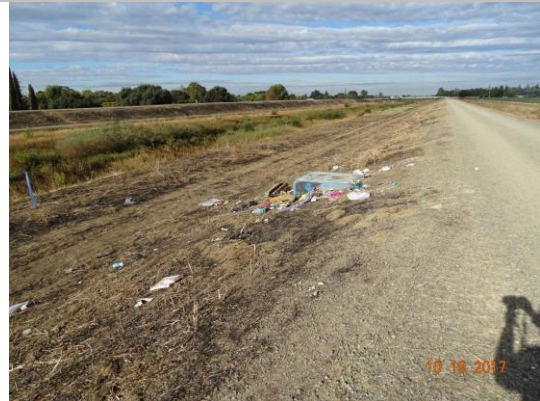
Photo 1 of 1 : FA_2017_NA0017_159_169_20171023_00443.jpg

LM Start	16.94	Rating **	M	Issue No.	169
LM End	16.94	Issue Type +	Ma	Location *	WS
Category	Earthen Levee			GPS Latitude/Longitude	
				Start	End
Item	Encroachments			37.986367 °	37.986367 °
				-121.259337 °	-121.259337 °
DWR ID	DWR_NA0017_15_f_2017_169				
Comment Code					
DE : Debris					
Inspector Comment

View of debris on the waterside slope of the levee. Fall 2017

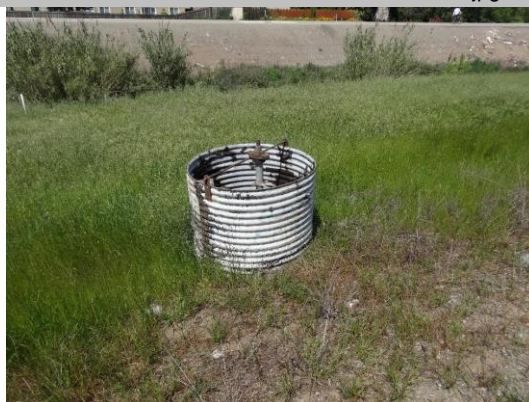
Photo 2 of 3 : UCIP_FA_2017_35203_63344.jpg

WS view: slide gate in CMP riser on levee slope. Slide gate handle missing.

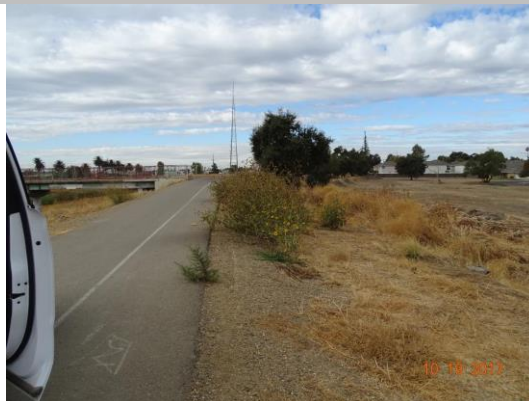
Photo 1 of 1 : FA_2017_NA0017_159_170_20171023_00444.jpg

LM Start	19.83	Rating **	M	Issue No.	170
LM End	20.13	Issue Type +	Ma	Location *	LS
Category	Earthen Levee			GPS Latitude/Longitude	
				Start	End
Item	Vegetation			37.994066 °	37.993659 °
				-121.283258 °	-121.288556 °
DWR ID	DWR_NA0017_15_f_2017_170				
Comment Code					
V1 : Control annual grass and weeds on the levee slopes and easements.					
Inspector Comment

View of vegetation on the landside shoulder of the levee. Fall 2017

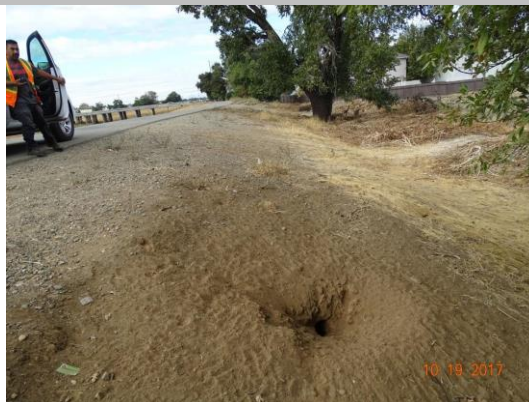
Photo 1 of 1 : FA_2017_NA0017_159_171_20171023_00444.jpg

LM Start	19.92	Rating **	M	Issue No.	171
LM End	19.92	Issue Type +	Ma	Location *	LS
Category	Earthen Levee			GPS Latitude/Longitude	
				Start	End
Item	Animal Control			37.993707 °	37.993707 °
				-121.284852 °	-121.284852 °
DWR ID	DWR_NA0017_15_f_2017_171				
Comment Code					
A3 : No rodents visible, but rodent burrows visible; need to backfill and compact or grout burrows.					
Inspector Comment

View of a rodent hole on the landside of the levee. Fall 2017

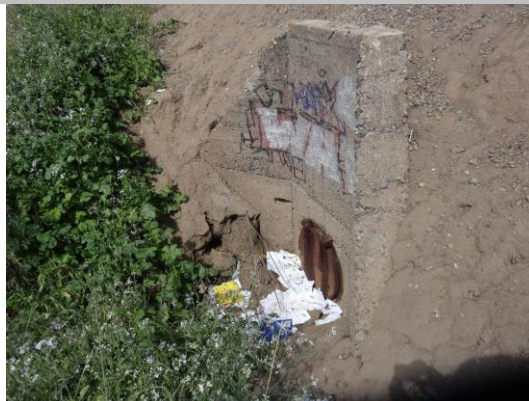
Photo 1 of 2 : UCIP_FA_2017_35263_63421.jpg

WS view: concrete headwall and steel pipe with flapgate on levee slope.
Vegetation and debris on spillway.

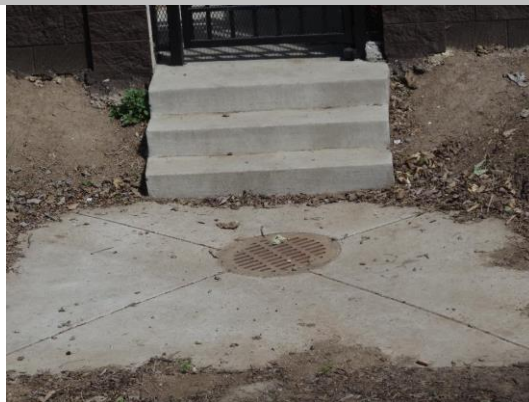
Photo 2 of 2 : UCIP_FA_2017_35263_63420.jpg

LS view: a manhole on levee toe.

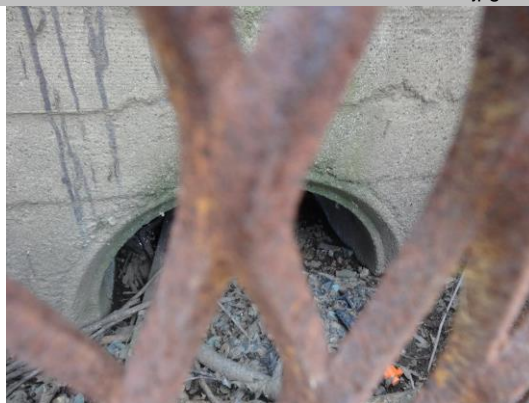
Photo 3 of 3 : UCIP_FA_2017_40412_63525.jpg

Item	DWR UCIP LMA Responsibility			37.992395 °	37.992395 °	
				-121.296512 °	-121.296512 °	
DWR ID						
Comment Code						
Inspector Comment						
FS_ID:40412 DS_ID:23279 EP_NO: 4583 Repair Type: Non-Urgent Crossing Status: Found UCIP Comments: Half inlet opening buried into mud. Needs cleaning and clearing. Intake on storm drain ditch. Trash rack on inlet. FIELD_STRUCT_DESC: 24-inch reinforced concrete drainage pipe through the levee, 12.5 feet below the crown. Concrete headwall and flap gate on the waterside (WS) end. Concrete headwall with flashboard slats on the landside (LS). (Permit No. 4583, 1964 - San Joaquin County Department of Public Works). [Additional Reference(s): DWR Levee Log, 1992. USACE San Joaquin O&M Manual 611.1, Volume F, (HLM 20.76)]. FS Date: 5/22/2014

LS view: partially buried intake pipe with trash rack on levee toe. Needs cleaning and clearing.

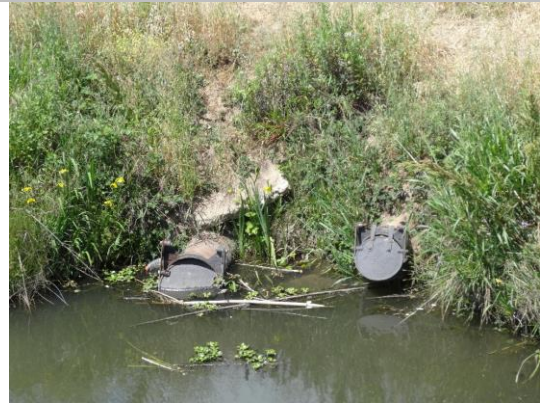
Photo 1 of 3 : UCIP_FA_2017_51409_63545.jpg

FS_ID:51409
DS_ID:23281
EP_NO: 2389
Repair Type: Urgent
Crossing Status: Found
UCIP Comments: 05/31/2016 same as last inspection. Need to contact owner to determine status. If crossing is no longer in use owner will need to coordinate with CVFPB to comply with Title 23. (O. Magana - DWR UCIP)05/22/2014 Flapgate does not fully close. (W. Wylie - DWR UCIP)
FIELD_STRUCT_DESC: 1 of 3: 16-inch steel drainage pipe through the levee, 4.6 feet below the crown. Flap gate on the waterside (WS) end. Siphon breakers in 42-inch concrete riser on the WS shoulder. Pump house on the landside (LS). (emergency work to remove silt and sand blocking discharge pipe work authorized under Permit No. 6809, 1969 - City of Stockton; 16-inch pipe authorized under Permit No. 2389, 1957 - City of Stockton). [Additional Reference(s): DWR Levee Log, 1976, 1977, 1978, 1987, 1990. USACE San Joaquin O&M Manual Unit 611, Part No. 1 – Mormon Slough Project, Unit 15 Mormon Slough: HLM 1.18 – 13.46, Unit 15 Diverting Canal: HLM 13.79 – 18.01, Unit 15 Calaveras River LB: 18.54-18.76, Unit 15 Calaveras River RB: HLM 19.35 – 25.38, Unit 16 Mormon Slough: 0.27 – 13.18, Unit 16 Diverting Canal: 14.71 – 17.79, Unit 16 Calaveras River: 18.98 – 23.36, Unit 17 Potter Creek RB: 0.33 – 0.60, Unit 18 Potter Creek LB: 0.00-0.55, (HLM 21.21)]

WS view: three (one not visible) steel outfall pipes on channel bank.

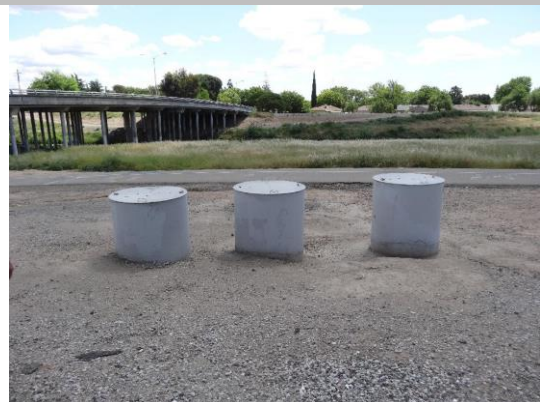
Photo 2 of 3 : UCIP_FA_2017_51409_63544.jpg

WS view: siphon breakers in concrete pipe risers on levee slope.

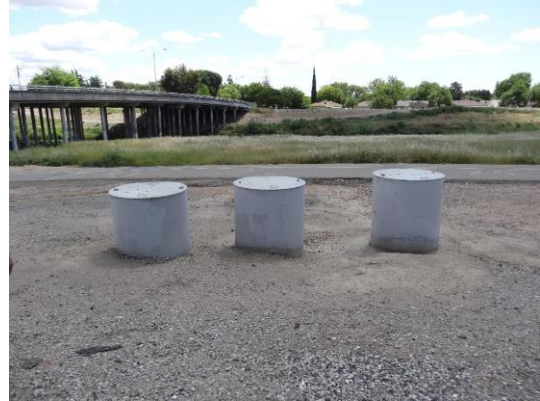
Photo 1 of 3 : UCIP_FA_2017_51410_63550.jpg

FS_ID:51410
DS_ID:23469
EP_NO: 6809
Repair Type: Urgent
Crossing Status: Found
UCIP Comments: 10/31/2016 same as last inspection. (O. Magana - DWR UCIP)05/22/2014 Flatgate was not fully closed. (W. Wylie - DWR UCIP)
FIELD_STRUCT_DESC: 2 of 3: 18-inch steel drainage pipe through the levee, 4.6 feet below the crown. Flap gate on the waterside (WS) end. Siphon breaker in 42-inch concrete riser located on the WS shoulder. Pump house is located on the landside (LS). In 2011, pipe section from pump station to riser was replaced. (emergency work to remove silt and sand blocking discharge pipe work authorized under Permit No. 6809, 1969 - City of Stockton; 18-inch pipe authorized under Permit No. 2389, 1957 - City of Stockton). [Additional Reference(s): DWR Levee Log, 1976, 1977, 1978, 1987, 1990. USACE San Joaquin O&M Manual Unit 611, Part No. 1 - Mormon Slough Project, Unit 15 Mormon Slough: HLM 1.18 - 13.46, Unit 15 Diverting Canal: HLM 13.79 - 18.01, Unit 15 Calaveras River LB: 18.54-18.76, Unit 15 Calaveras River RB: HLM 19.35 - 25.38, Unit 16 Mormon Slough: 0.27 - 13.18, Unit 16 Diverting Canal: 14.71 - 17.79, Unit 16 Calaveras River: 18.98 - 23.36, Unit 17 Potter Creek RB: 0.33 - 0.60, Unit 18 Potter Creek LB: 0.00-0.55, (HLM 21.21)]

WS view: siphon breakers in concrete pipe risers on levee slope.

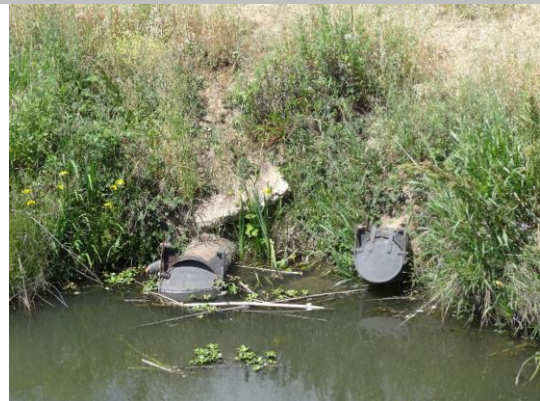
Photo 2 of 3 : UCIP_FA_2017_51410_63549.jpg

WS view: three (one not visible) steel outfall pipes on channel bank.

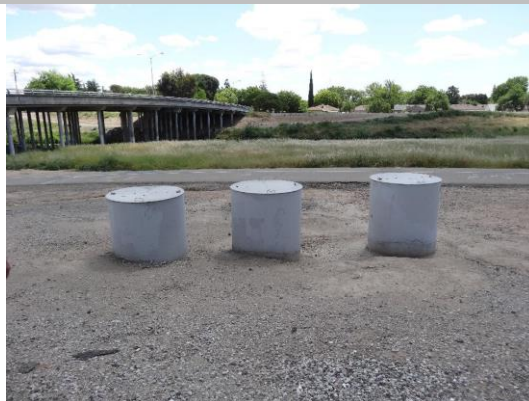
Photo 1 of 3 : UCIP_FA_2017_35345_63557.jpg

FS_ID:35345
DS_ID:23470
EP_NO: 2389
Repair Type: Non-Urgent
Crossing Status: Found
UCIP Comments: Pipe was not visible due to vegetation or buried on waterside.
FIELD_STRUCT_DESC: 3 of 3: 24-inch steel pipes through the levee 4.6-feet below the crown. Flap gates on the waterward end. Siphon breakers in 42-inch concrete riser on the waterward shoulder. Pump house on the landward side. Chain link fence around the pump house. (emergency work to remove silt and sand blocking discharge pipe work authorized under Permit No. 6809, 1969 - City of Stockton; 24-inch pipe authorized under Permit No. 2389 - City of Stockton). [Additional Reference(s): DWR Levee Log, 1976, 1977, 1978, 1987, 1990. USACE San Joaquin O&M Manual Unit 611, Part No. 1 – Mormon Slough Project, Unit 15 Mormon Slough: HLM 1.18 – 13.46, Unit 15 Diverting Canal: HLM 13.79 – 18.01, Unit 15 Calaveras River LB: 18.54-18.76, Unit 15 Calaveras River RB: HLM 19.35 – 25.38, Unit 16 Mormon Slough: 0.27 – 13.18, Unit 16 Diverting Canal: 14.71 – 17.79, Unit 16 Calaveras River: 18.98 – 23.36, Unit 17 Potter Creek RB: 0.33 – 0.60, Unit 18 Potter Creek LB: 0.00-0.55, (HLM 21.21)]

WS view: siphon breakers in concrete pipe risers on levee slope.

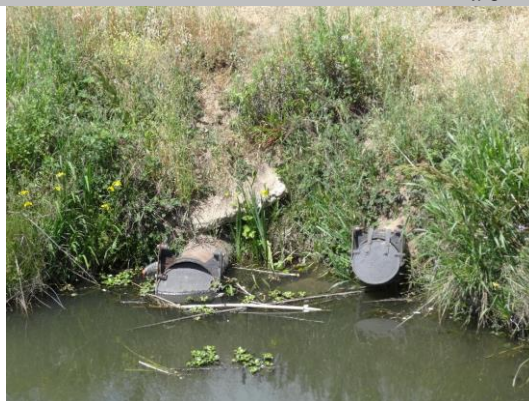
Photo 2 of 3 : UCIP_FA_2017_35345_63556.jpg

WS view: three (one not visible) steel outfall pipes on channel bank.

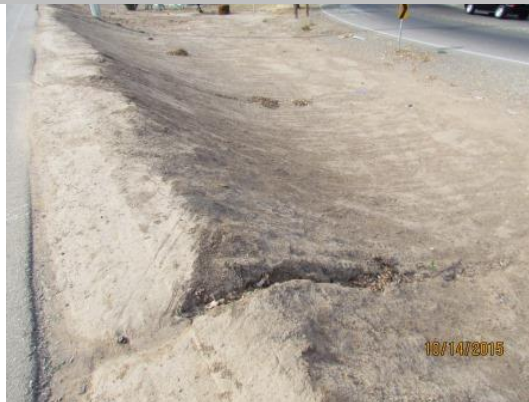
Photo 1 of 1 : FA_2017_NA0017_159_172_20170921_00088.jpg

LM Start	21.25	Rating **	M	Issue No.	172
LM End	21.25	Issue Type +	Ma	Location *	LS
Category	Earthen Levee			GPS Latitude/Longitude	
				Start	End
Item	Erosion / Bank Caving			37.988969 °	37.988969 °
				-121.307009 °	-121.307009 °
DWR ID	DWR_NA0017_15_f_2015_172				
Comment Code					
E2 : Schedule repair of erosion site prior to the next inspection.					
Inspector Comment					
Runoff.

Erosion was found on the landside of the levee looking downstream.

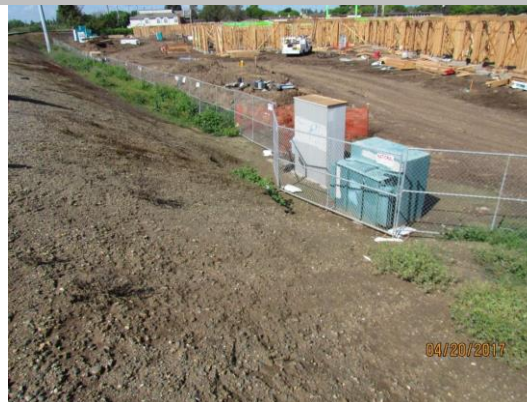
Photo 1 of 1 : FA_2017_NA0017_159_240_20170921_00117.jpg

LM Start	21.95	Rating **	M	Issue No.	240	
LM End	21.95	Issue Type +	Ma	Location *	LS	
Category	Earthen Levee			GPS Latitude/Longitude		
				Start		End
Item	Erosion / Bank Caving			37.981308 °		37.981308 °
				-121.314831 °		-121.314831 °
DWR ID	DWR_NA0017_15_s_2017_240					
Comment Code						
E1 : Note and monitor erosion site.						
Inspector Comment						
Landside toe erosion.

View of erosion on the landside toe of the levee.

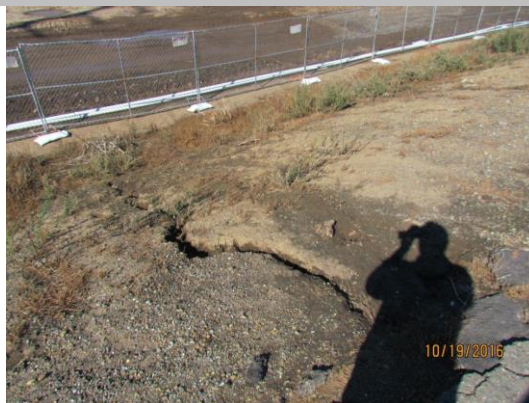
Photo 1 of 2 : FA_2017_NA0017_159_173_20170921_00089.jpg

LM Start	21.96	Rating **	M	Issue No.	173
LM End	21.96	Issue Type +	Ma	Location *	LS
Category	Earthen Levee			GPS Latitude/Longitude	
				Start	End
Item	Erosion / Bank Caving			37.981147 °	37.981147 °
				-121.315071 °	-121.315071 °
DWR ID	DWR_NA0017_15_s_2012_173				
Comment Code					
E2 : Schedule repair of erosion site prior to the next inspection.					
Inspector Comment					
Runoff.

Updated picture of erosion due to runoff on the landside slope of the levee during fall 2016 inspection.

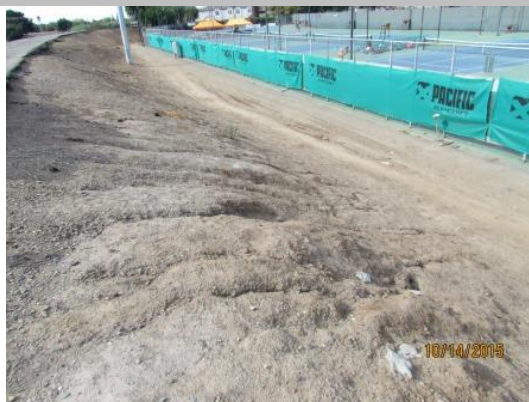
Photo 2 of 2 : FA_2017_NA0017_159_173_20170921_00090.jpg

View of the erosion caused by run off on the landside slope of the levee looking downstream during fall 2015 inspection.

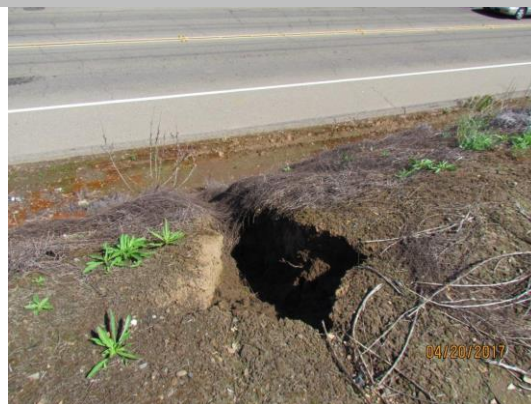
Photo 1 of 1 : FA_2017_NA0017_159_185_20170921_00094.jpg

LM Start	22.88	Rating **	M	Issue No.	185
LM End	22.88	Issue Type +	Ma	Location *	LS
Category	Earthen Levee			GPS Latitude/Longitude	
				Start	End
Item	Erosion / Bank Caving			37.981278 °	37.981278 °
				-121.330566 °	-121.330566 °
DWR ID	DWR_NA0017_15_f_2016_185				
Comment Code					
E2 : Schedule repair of erosion site prior to the next inspection.					
Inspector Comment					
Runoff

View of an erosion due to runoff on the landside of the levee. Spring 2017

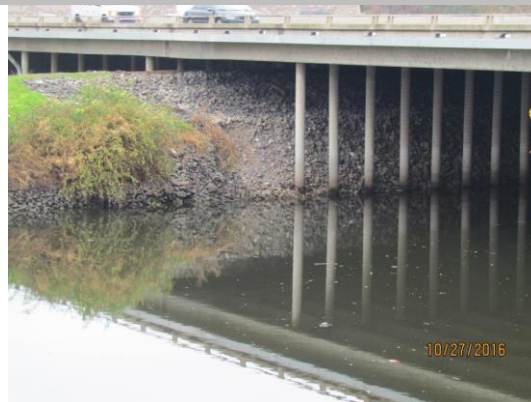
Photo 1 of 1 : FA_2017_NA0017_159_223_20170921_00110.jpg

LM Start	23.55	Rating **	A/W	Issue No.	223
LM End	23.55	Issue Type +	Ma	Location *	WS
Category	Earthen Levee			GPS Latitude/Longitude	
				Start	End
Item	Riprap Revetments			37.979282 °	37.979282 °
				-121.341686 °	-121.341686 °
DWR ID	DWR_NA0017_15_f_2016_223				
Comment Code					
Inspector Comment					
Wrong revetment size was placed by Caltrans in Fall 2012 under permit #18562. An NOV was issued to Caltrans. They repaired the left bank, but have not repaired the right bank of the levee. Caltrans will be responsible for any repairs at this location.

View of deteriorating revetments on the waterside toe of the levee. The picture was taken from the opposite side of the levee. Fall 2016

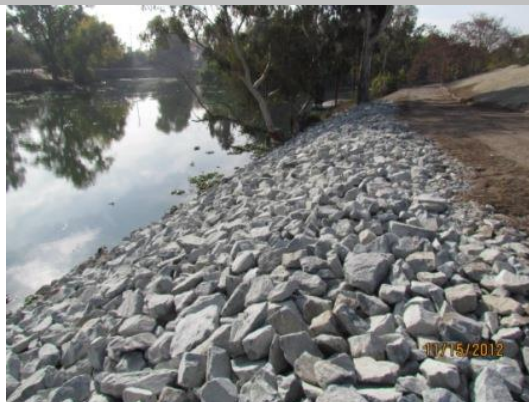
Photo 1 of 1 : FA_2017_NA0017_159_189_20170921_00095.jpg

Revetments were placed by the LMA on the waterside slope of the levee looking downstream.

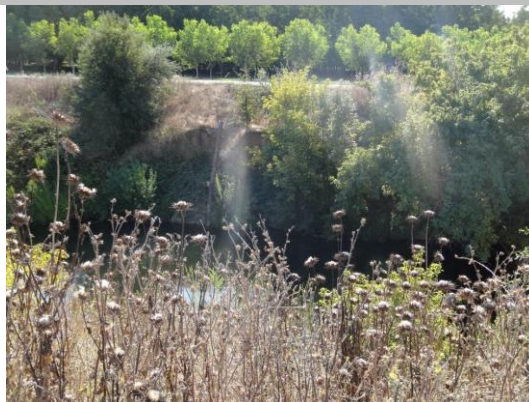
Photo 1 of 4 : SJR2017_NA0017U16RM22.74_1.jpg

Comment Code					
Inspector Comment					
08/30/2017: No significant change observed.					
08/16/2016: No significant change observed.					
08/12/2015: No significant change observed.					
08/20/2014: No significant change observed.					
09/12/2013: No significant change observed.					
08/22/2012: The erosion was surveyed and documented for monitoring purpose. There is no levee structure on the site, only high ground protecting the land behind. The levee crest width and levee height were not measured or estimated in the field.					
There is a drainage pipe at the site, which might have caused the problem at one pocket erosion. [2017 Site ID:NA0017U16RM22.74]

View of the site from right river bank.

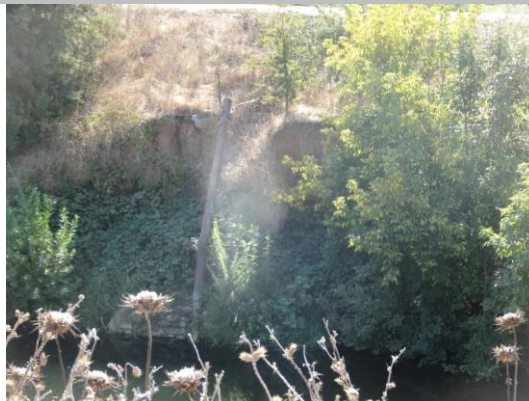
Photo 2 of 4 : SJR2017_NA0017U16RM22.74_2.jpg

Close view of the erosion.

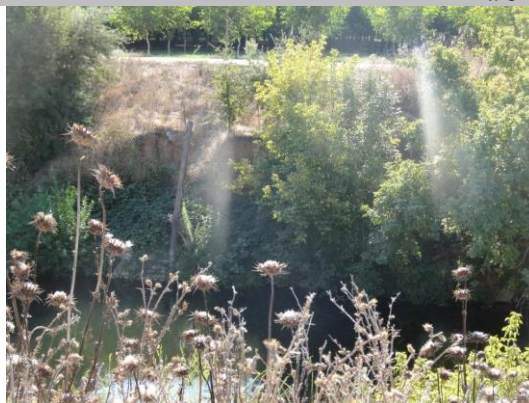
Photo 3 of 4 : SJR2017_NA0017U16RM22.74_3.jpg

Close view of the erosion. Note the drainage pipe at the site.

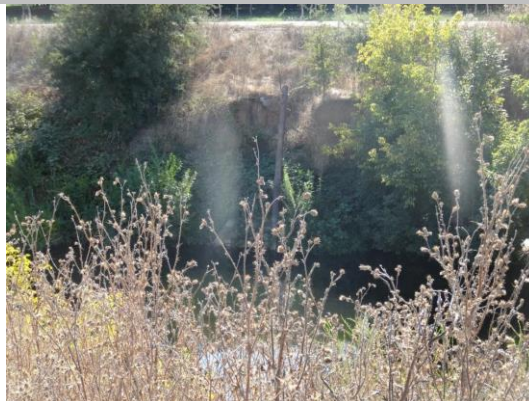
Photo 4 of 4 : SJR2017_NA0017U16RM22.74_4.jpg

LM Start	0.93	Rating **	M	Issue No.	83 (cont)
LM End	0.95	Issue Type +	Ma	Location *	WS
Category	Supplemental			GPS Latitude/Longitude	
				Start	End
Item	DWR Erosion Survey			38.042833 °	38.042833 °
				-121.025776 °	-121.025776 °
DWR ID	NA0017U16RM22.74				
Comment Code					
Inspector Comment					
08/30/2017: No significant change observed. 08/16/2016: No significant change observed. 08/12/2015: No significant change observed. 08/20/2014: No significant change observed. 09/12/2013: No significant change observed. 08/22/2012: The erosion was surveyed and documented for monitoring purpose. There is no levee structure on the site, only high ground protecting the land behind. The levee crest width and levee height were not measured or estimated in the field. There is a drainage pipe at the site, which might have caused the problem at one pocket erosion. [2017 Site ID:NA0017U16RM22.74]

Close view of the site.

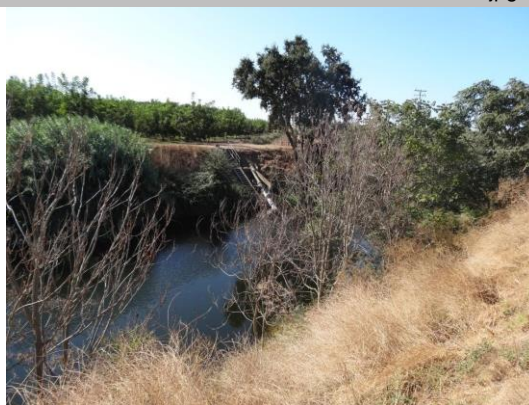
Photo 1 of 3 : SJR2017_NA0017U16RM22.58_1.jpg

LM Start	1.12	Rating **	U	Issue No.	82
LM End	1.12	Issue Type +	Ma	Location *	WS
Category	Supplemental			GPS Latitude/Longitude	
				Start	End
Item	DWR Erosion Survey			38.040757 °	38.040757 °
				-121.027786 °	-121.027786 °
DWR ID	NA0017U16RM22.58				
Comment Code					
Inspector Comment					
08/30/2017: No significant change observed. 08/16/2016: No significant change observed. 08/12/2015: No significant change observed. 08/20/2014: No significant change observed. 09/12/2013: No significant change observed. 08/22/2012: The erosion is at the outside corner of a river bend, and next to a tree at the levee toe. Irrigation structure presents at the site. There is no levee structure on site. The levee crest width and levee height were not measured or estimated in the field. [2017 Site ID:NA0017U16RM22.58]

Front view of the erosion. The erosion is next to a tree at the levee toe.

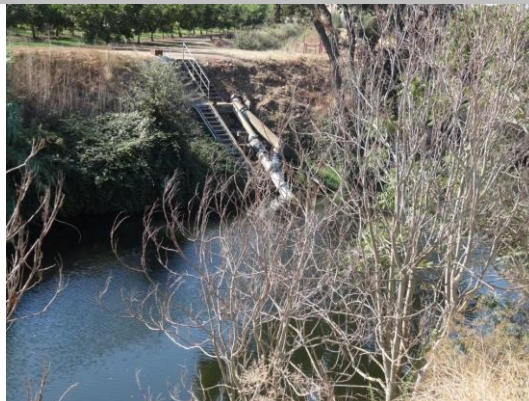
Photo 2 of 3 : SJR2017_NA0017U16RM22.58_2.jpg

Close view of the erosion.

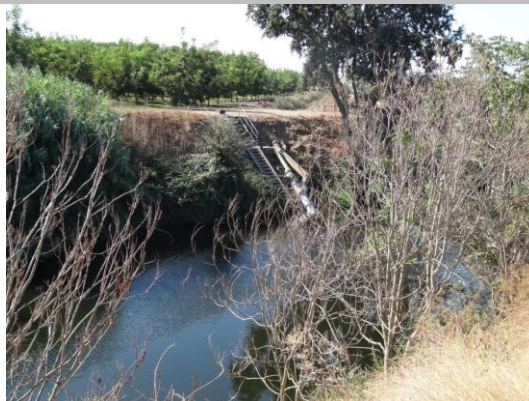
Photo 3 of 3 : SJR2017_NA0017U16RM22.58_3.jpg

Front view of the erosion.

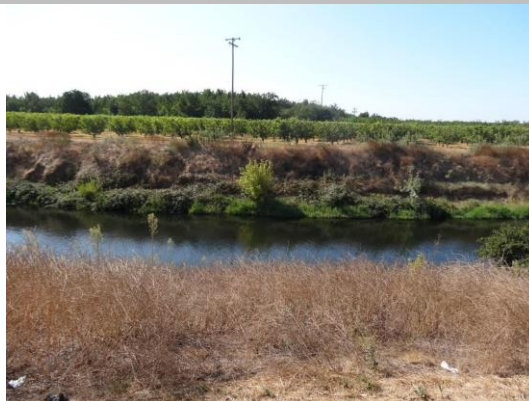
Photo 1 of 4 : SJR2017_NA0017U16RM22.15_1.jpg

LM Start	1.67	Rating **	M	Issue No.	80
LM End	1.67	Issue Type +	Ma	Location *	WS
Category	Supplemental			GPS Latitude/Longitude	
				Start	End
Item	DWR Erosion Survey			38.038751 °	38.038751 °
				-121.037347 °	-121.037347 °
DWR ID	NA0017U16RM22.15				
Comment Code					
Inspector Comment					
08/30/2017: No significant change observed.					
08/16/2016: No significant change observed.					
08/12/2015: No significant change observed.					
08/20/2014: No significant change observed.					
09/12/2013: No significant change observed.					
08/22/2012: The berm is estimated at 10 ft. Dense vegetation on site.					
There is no levee structure on site. The levee crest width and levee height were not measured or estimated in the field. [2017 Site ID:NA0017U16RM22.15]

Front view of the erosion.

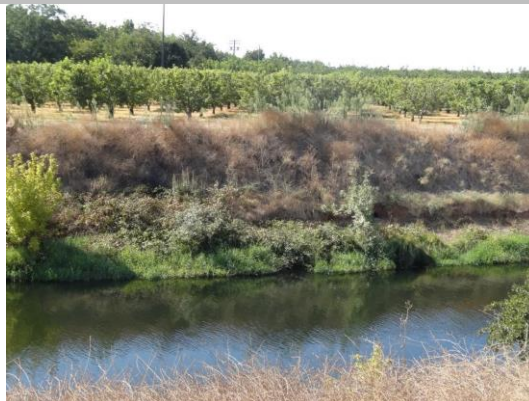
Photo 2 of 4 : SJR2017_NA0017U16RM22.15_2.jpg

Close view of the erosion.

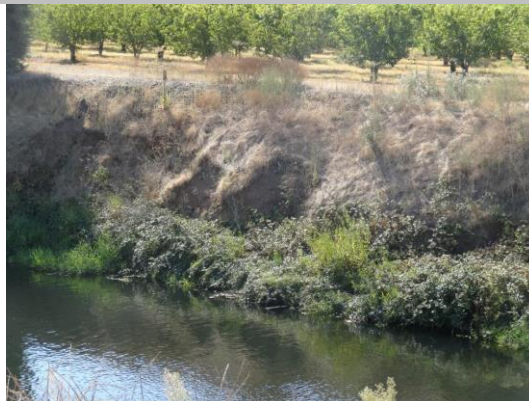
Photo 3 of 4 : SJR2017_NA0017U16RM22.15_3.jpg

Close view of the erosion.

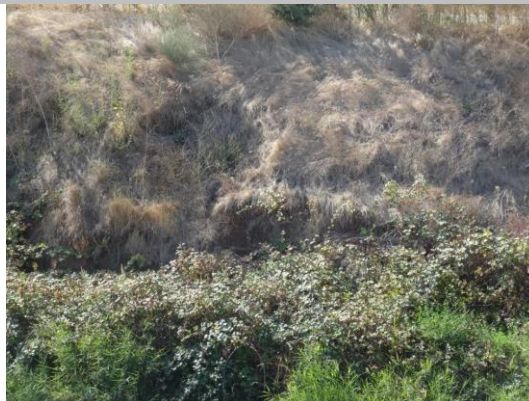
Photo 4 of 4 : SJR2017_NA0017U16RM22.15_4.jpg

Close view of the erosion. Note the dense vegetation at the site.

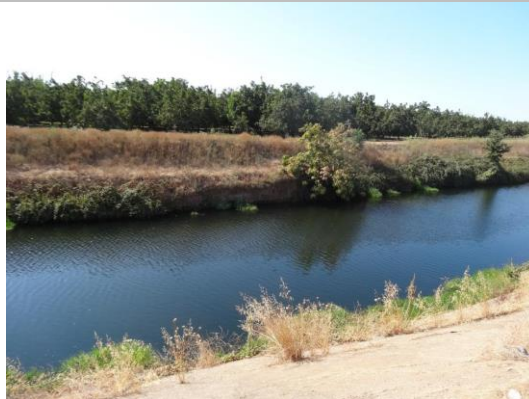
Photo 1 of 4 : SJR2017_NA0017U16RM21.95_1.jpg

LM Start	1.75	Rating **	M	Issue No.	76
LM End	1.76	Issue Type +	Ma	Location *	WS
Category	Supplemental			GPS Latitude/Longitude	
				Start	End
Item	DWR Erosion Survey			38.038080 °	38.038080 °
				-121.038676 °	-121.038676 °
DWR ID	NA0017U16RM21.95				
Comment Code					
Inspector Comment					
08/30/2017: No significant change observed.					
08/16/2016: No significant change observed.					
08/12/2015: No significant change observed.					
08/20/2014: No significant change observed.					
09/12/2013: No significant change observed.					
08/22/2012: The erosion is covered by dense vegetation. There is no levee structure on site. The levee crest width and levee height were not measured or estimated in the field. [2017 Site ID:NA0017U16RM21.95]

Front view of the erosion site.

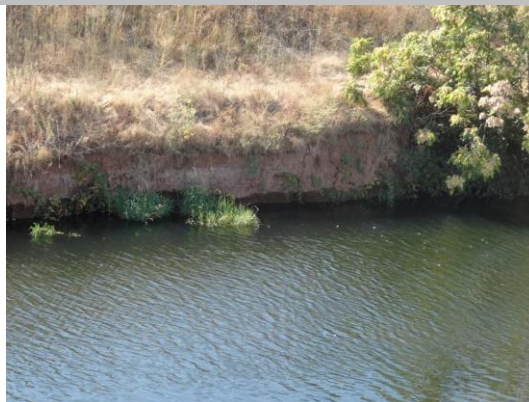
Photo 2 of 4 : SJR2017_NA0017U16RM21.95_2.jpg

Close view of the erosion.

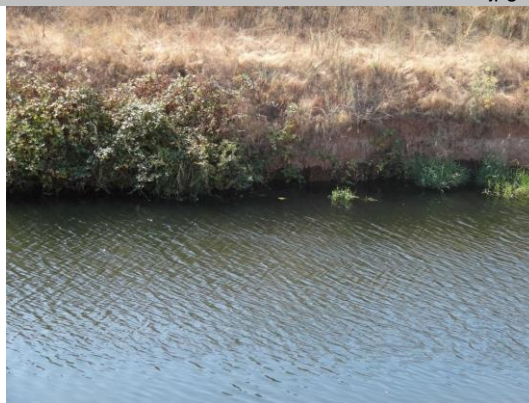
Photo 3 of 4 : SJR2017_NA0017U16RM21.95_3.jpg

Close view of the erosion.

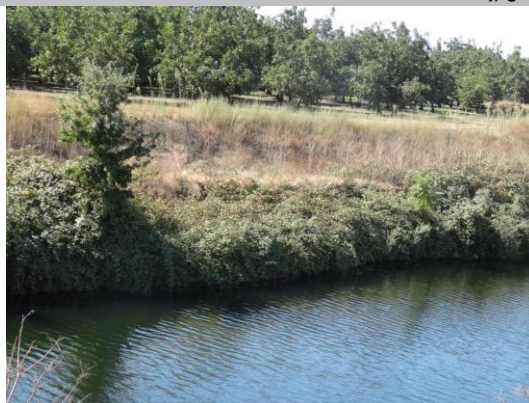
Photo 1 of 4 : SJR2017_NA0017U16RM21.94_1.jpg

LM Start	1.77	Rating **	M	Issue No.	75
LM End	1.78	Issue Type +	Ma	Location *	WS
Category	Supplemental			GPS Latitude/Longitude	
				Start	End
Item	DWR Erosion Survey			38.037906 °	38.037906 °
				-121.038949 °	-121.038949 °
DWR ID	NA0017U16RM21.94				
Comment Code					
Inspector Comment					
08/30/2017: No significant change observed. The site is covered by dense vegetation.					
08/16/2016: No significant change observed.					
08/12/2015: No significant change observed.					
08/20/2014: No significant change observed					
09/12/2013: No significant change observed.					
08/22/2012: Site is covered by dense vegetation. Berm width is estimated as 5 ft. There is no levee structure on site. The levee crest width and levee height were not measured or estimated in the field.					
[2017 Site ID:NA0017U16RM21.94]

Looking at the erosion from right river bank.

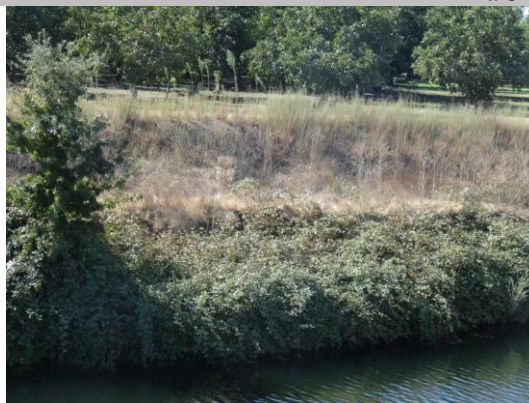
Photo 2 of 4 : SJR2017_NA0017U16RM21.94_2.jpg

Front view of the erosion.

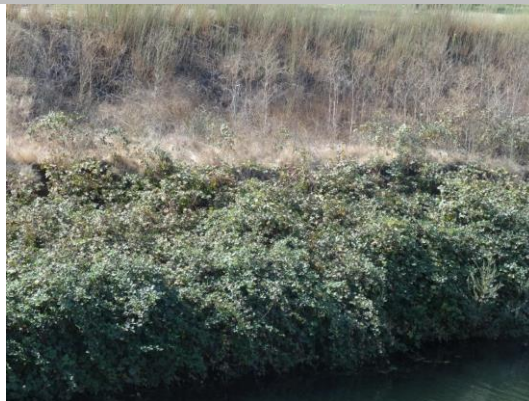
Photo 3 of 4 : SJR2017_NA0017U16RM21.94_3.jpg

08/30/2017: No significant change observed. The site is covered by dense vegetation.
 08/16/2016: No significant change observed.
 08/12/2015: No significant change observed.
 08/20/2014: No significant change observed.
 09/12/2013: No significant change observed.
 08/22/2012: Site is covered by dense vegetation. Berm width is estimated as 5 ft. There is no levee structure on site. The levee crest width and levee height were not measured or estimated in the field.
 [2017 Site ID:NA0017U16RM21.94]

Close view of the erosion.

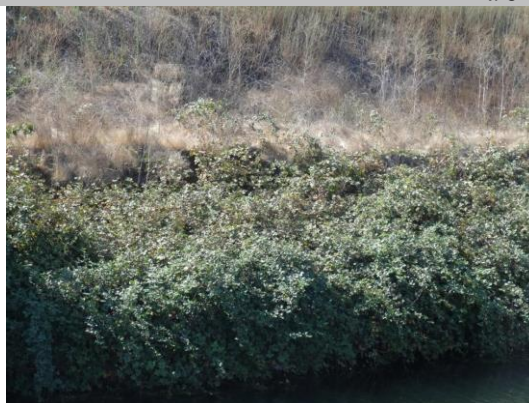
Photo 4 of 4 : SJR2017_NA0017U16RM21.94_4.jpg

Close view of the erosion. Note the dense vegetation at the site.

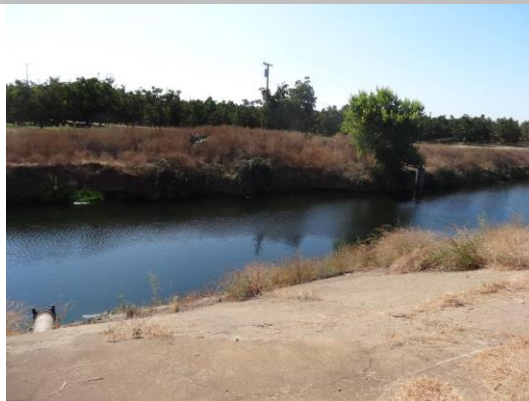
Photo 1 of 4 : SJR2017_NA0017U16RM21.05_1.jpg

LM Start	1.88	Rating **	M	Issue No.	74
LM End	1.90	Issue Type +	Ma	Location *	WS
Category	Supplemental			GPS Latitude/Longitude	
				Start	End
Item	DWR Erosion Survey			38.036549 °	38.036549 °
				-121.040302 °	-121.040302 °
DWR ID	NA0017U16RM21.05				
Comment Code					
Inspector Comment					
08/30/2017: No significant change observed. 08/16/2016: No significant change observed. 08/12/2015: No significant change observed. 08/20/2014: No significant change observed. 09/12/2013: No significant change observed. 08/22/2012: Berm width is estimated as 5 ft. There is no levee structure on site. The levee crest width and levee height were not measured or estimated in the field. [2017 Site ID:NA0017U16RM21.05]

Front view of the erosion

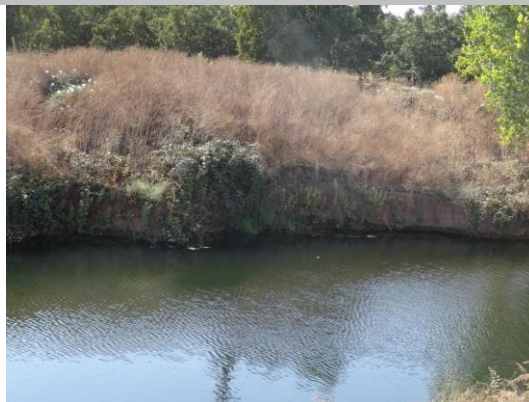
Photo 2 of 4 : SJR2017_NA0017U16RM21.05_2.jpg

Close view of the erosion.

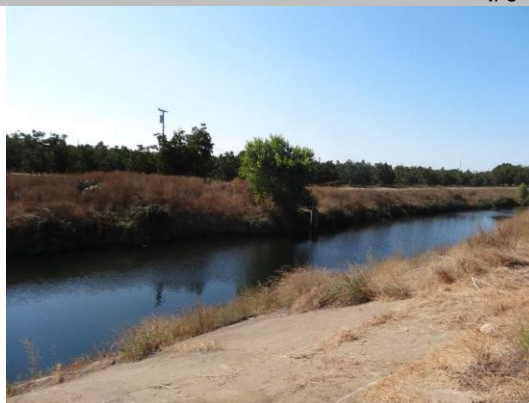
Photo 3 of 4 : SJR2017_NA0017U16RM21.05_3.jpg

Front view of the erosion.

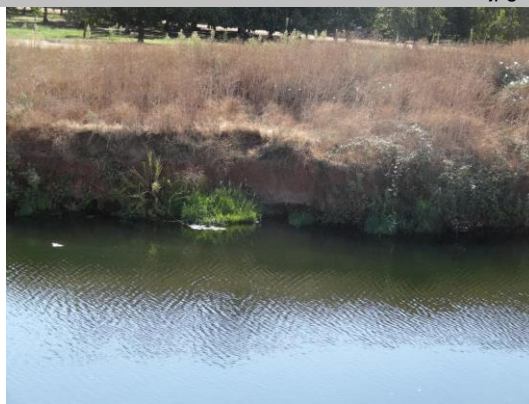
Photo 4 of 4 : SJR2017_NA0017U16RM21.05_4.jpg

Close view of the erosion.

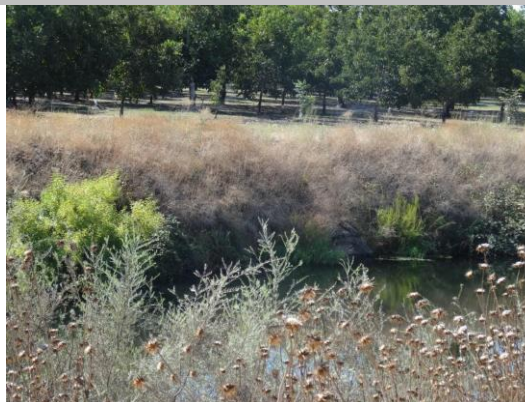
Photo 1 of 4 : SJR2017_NA0017U16RM20.62_1.jpg

LM Start	2.30	Rating **	U	Issue No.	66
LM End	2.31	Issue Type +	Ma	Location *	WS
Category	Supplemental			GPS Latitude/Longitude	
				Start	End
Item	DWR Erosion Survey			38.032202 °	38.032202 °
				-121.045226 °	-121.045226 °
DWR ID	NA0017U16RM20.62				
Comment Code					
Inspector Comment					
08/30/2017: No significant change observed.					
08/16/2016: No significant change observed.					
08/12/2015: No significant change observed.					
08/20/2014: No significant change has been observed.					
09/12/2013: No significant change observed.					
08/22/2012: The erosion was first reported in the 2012 spring levee inspection report. There is no levee structure on site. The levee crest width and levee height were not measured or estimated in the field.					
[2017 Site ID:NA0017U16RM20.62]

Front view of the site.

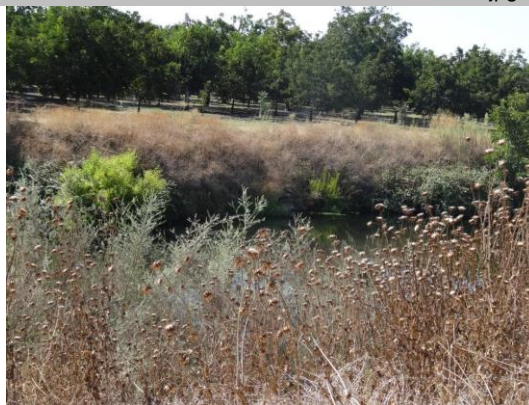
Photo 2 of 4 : SJR2017_NA0017U16RM20.62_2.jpg

Close view of the erosion. Note the vegetation at the site.

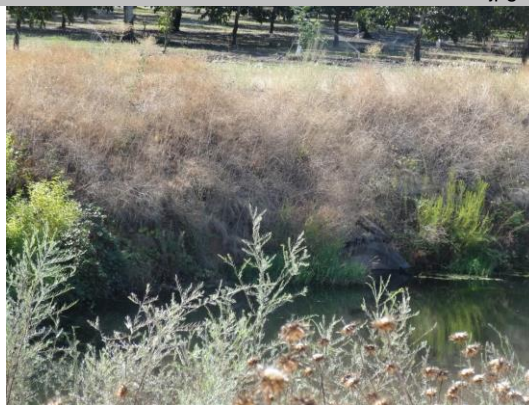
Photo 3 of 4 : SJR2017_NA0017U16RM20.62_3.jpg

Close view of the erosion.

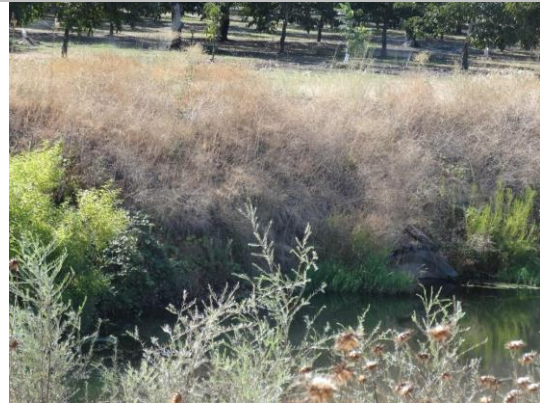
Photo 4 of 4 : SJR2017_NA0017U16RM20.62_4.jpg

Close view of the site.

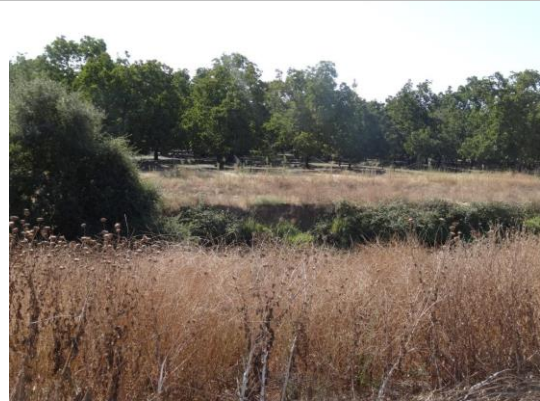
Photo 1 of 4 : SJR2017_NA0017U16RM20.71_1.jpg

LM Start	2.30	Rating **	M	Issue No.	70
LM End	2.31	Issue Type +	Ma	Location *	WS
Category	Supplemental			GPS Latitude/Longitude	
				Start	End
Item	DWR Erosion Survey			38.033072 °	38.033072 °
				-121.044970 °	-121.044970 °
DWR ID	NA0017U16RM20.71				
Comment Code					
Inspector Comment					
08/30/2017: No significant change observed.					
08/16/2016: No significant change observed.					
08/12/2015: No significant change observed.					
08/20/2014: No significant change observed.					
09/12/2013: No significant change observed.					
08/22/2012: Site is covered with dense vegetation. There is no levee structure on site. The levee crest width and levee height were not measured or estimated in the field. [2017 Site ID:NA0017U16RM20.71]

Front view of the site from the levee top on the other side of the river.

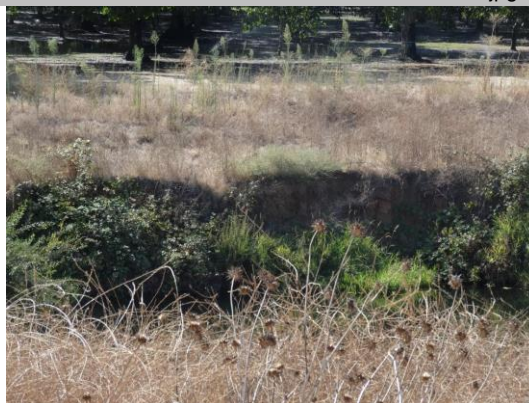
Photo 2 of 4 : SJR2017_NA0017U16RM20.71_2.jpg

08/30/2017: No significant change observed.
 08/16/2016: No significant change observed.
 08/12/2015: No significant change observed.
 08/20/2014: No significant change observed.
 09/12/2013: No significant change observed.
 08/22/2012: Site is covered with dense vegetation. There is no levee structure on site. The levee crest width and levee height were not measured or estimated in the field. [2017 Site ID:NA0017U16RM20.71]

Close view of the erosion. Site is covered with vegetation and trees.

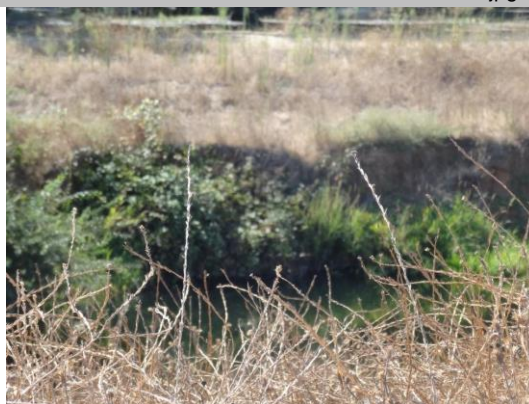
Photo 3 of 4 : SJR2017_NA0017U16RM20.71_3.jpg

Close view of the erosion.
