**Flood Control Project Maintenance
Levee Inspections**

Maintenance Issue Types Only, Levee Inspection Report By Mile - Fall 2017

San Joaquin County Flood Control and Water Conservation District

Waterway	Bank	Unit Miles	Inspection Start/End	Inspector
Unit No. 01 Littlejohn Creek	Left	2.59	10/17/2017 10/17/2017	Pavel Kazi

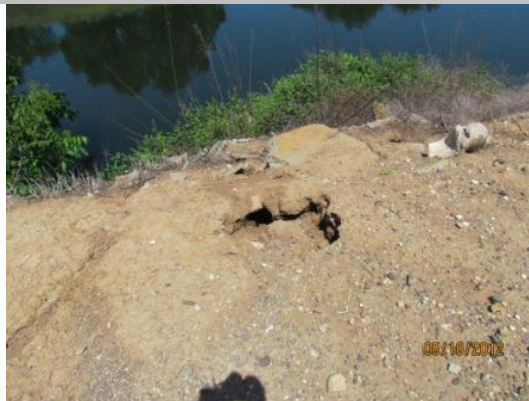
Photo 2 of 2 : FA_2017_NA0017_160_213_20171016_00143.jpg

LM Start	2.35	Rating **	A/W	Issue No.	213 (cont)	
LM End	2.35	Issue Type +	Ma	Location *	WS	
Category	Earthen Levee			GPS Latitude/Longitude		
				Start	End	
Item	Slope Stability			38.031763 °	38.031763 °	
				-121.045808 °	-121.045808 °	
DWR ID	DWR_NA0017_16_f_2012_213					
Comment Code						
S1 : Repair slope instability.						
Inspector Comment

Slope instability was found on the waterside of the levee looking upstream.

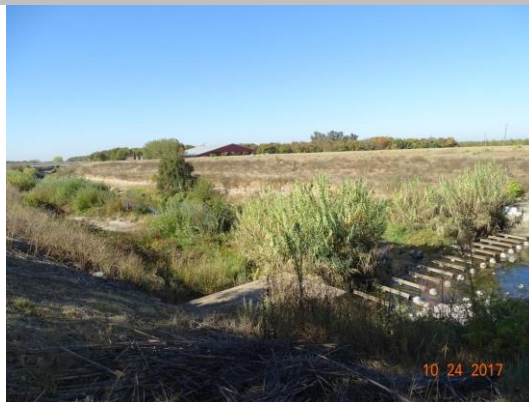
Photo 1 of 1 : FA_2017_NA0017_160_247_20171027_00431.jpg

LM Start	2.44	Rating **	M	Issue No.	247
LM End	2.44	Issue Type +	Ma	Location *	
Category	Rivers, Channels & Designated Floodways			GPS Latitude/Longitude	
				Start	End
Item	Vegetation & Obstructions			38.030668 °	38.030668 °
				-121.046842 °	-121.046842 °
DWR ID	DWR_NA0017_16_f_2017_247				
Comment Code					
Inspector Comment					
Arundo in the channel may slow the capacity of the channel.

View of arundo in the channel looking downstream. Fall 2017

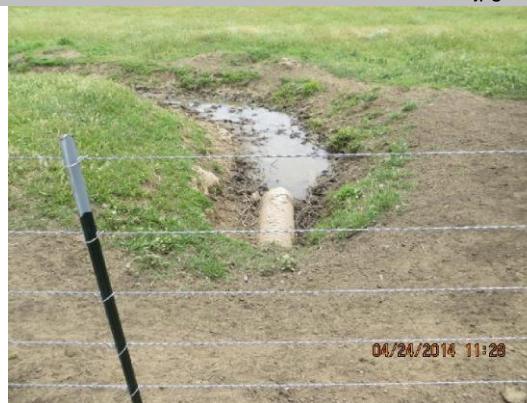
Photo 1 of 2 : UCIP_FA_2017_35551_64000.jpg

LM Start	2.45	Rating **	M	Issue No.	806
LM End	2.45	Issue Type +	Ma	Location *	
Category	Supplemental			GPS Latitude/Longitude	
				Start	End
Item	DWR UCIP LMA Responsibility			38.030548 °	38.030548 °
				-121.046998 °	-121.046998 °
DWR ID					
Comment Code					
Inspector Comment					
FS_ID:35551					
DS_ID:23323					
EP_NO: N/A					
Repair Type: Non-Urgent					
Crossing Status: Found					
UCIP Comments: Heavy vegetation obscuring outlet. remove vegetation and verify flapgate installed.					
FIELD_STRUCT_DESC: 18-inch corrugated metal drainage pipe, 3 feet below the roadway. Grouted spillway. [Additional Reference(s): DWR Levee Log, 1992. USACE San Joaquin O&M Manual 611.1, Volume F, (HLM 2.52)].					
FS Date: 4/24/2014

Pipe visible on LS toe.

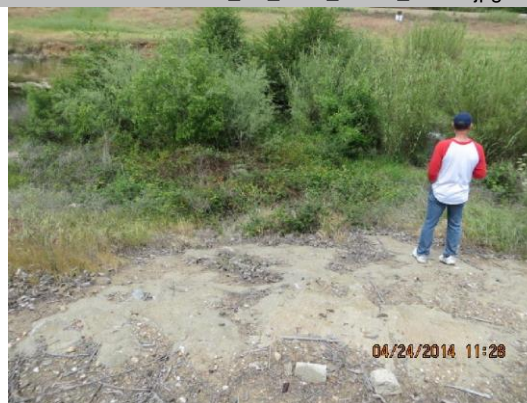
Photo 2 of 2 : UCIP_FA_2017_35551_63999.jpg

Grout over pipe on WS. Heavy vegetation blocking view of outlet.

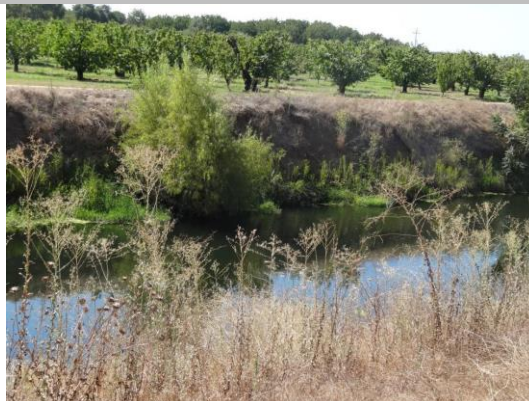
Photo 2 of 4 : SJR2017_NA0017U16RM20_2.jpg

08/30/2017: No significant change observed.
 08/16/2016: No significant change observed.
 08/12/2015: No significant change observed.
 08/20/2014: No significant change observed.
 09/12/2013: No significant change observed.
 08/22/2012: Site Comprised of series of pocket and scarp erosions. Some of erosions are covered by grass or shrubs. There is no levee structure on site. The levee crest width and levee height were not measured or estimated in the field. [2017 Site ID:NA0017U16RM20]

Close view of the erosion.

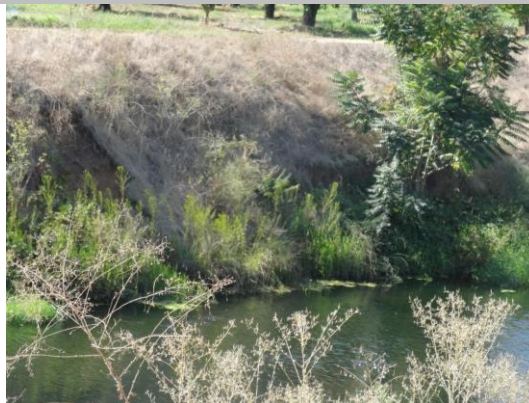
Photo 3 of 4 : SJR2017_NA0017U16RM20_3.jpg

Close view of the erosion.

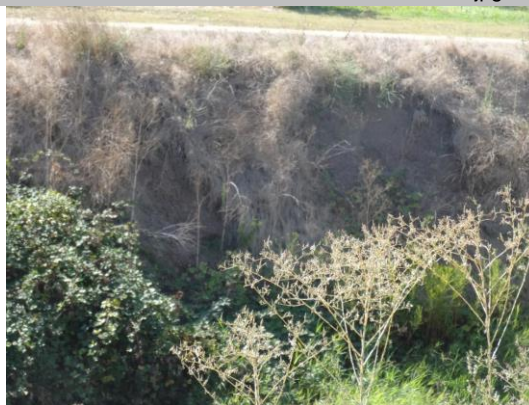
Photo 4 of 4 : SJR2017_NA0017U16RM20_4.jpg

LM Start	2.85	Rating **	U	Issue No.	64 (cont)
LM End	2.91	Issue Type +	Ma	Location *	WS
Category	Supplemental			GPS Latitude/Longitude	
				Start	End
Item	DWR Erosion Survey			38.026670 °	38.026670 °
				-121.053031 °	-121.053031 °
DWR ID	NA0017U16RM20				
Comment Code					
Inspector Comment					
08/30/2017: No significant change observed. 08/16/2016: No significant change observed. 08/12/2015: No significant change observed. 08/20/2014: No significant change observed. 09/12/2013: No significant change observed. 08/22/2012: Site Comprised of series of pocket and scarp erosions. Some of erosions are covered by grass or shrubs. There is no levee structure on site. The levee crest width and levee height were not measured or estimated in the field. [2017 Site ID:NA0017U16RM20]

Close view of the scarp erosion. Note the small tree at the erosion site.

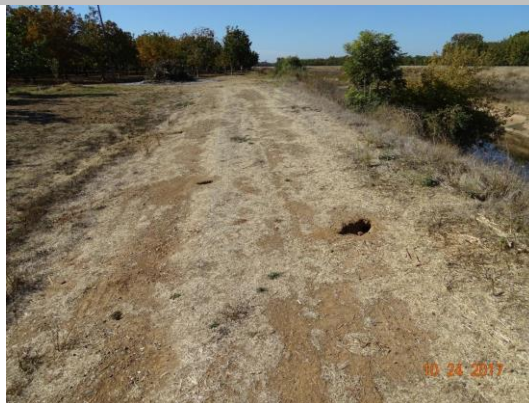
Photo 1 of 1 : FA_2017_NA0017_160_252_20171027_00432.jpg

LM Start	3.14	Rating **	M	Issue No.	252
LM End	3.14	Issue Type +	Ma	Location *	CR
Category	Earthen Levee			GPS Latitude/Longitude	
				Start	End
Item	Animal Control			38.024234 °	38.024234 °
				-121.056615 °	-121.056615 °
DWR ID	DWR_NA0017_16_f_2017_252				
Comment Code					
A1 : Exterminate rodents and backfill and compact or grout burrows.					
Inspector Comment					
Rodent holes may damage the patrol road.

View rodent holes on the crown of the levee looking downstream. Fall 2017

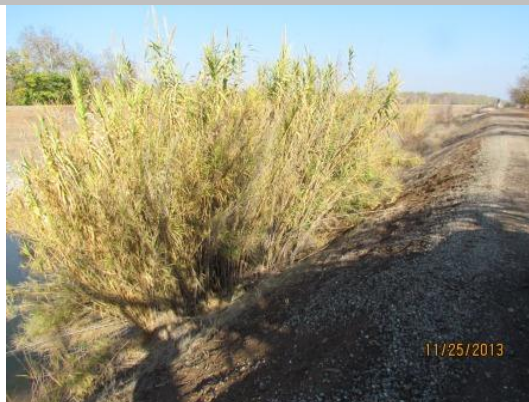
Photo 1 of 1 : FA_2017_NA0017_160_152_20171016_00124.jpg

LM Start	3.48	Rating **	A/W	Issue No.	152
LM End	3.48	Issue Type +	Ma	Location *	WS
Category	Earthen Levee			GPS Latitude/Longitude	
				Start	End
Item	Vegetation			38.020965 °	38.020965 °
				-121.061215 °	-121.061215 °
DWR ID	DWR_NA0017_16_f_2013_152				
Comment Code					
V2 : Remove the wild growth other than native grasses from the levee slopes.					
Inspector Comment					
Arundo was obstructing the inspection of the channel from the patrol road.

Arundo was found on the waterside toe of the levee looking upstream.

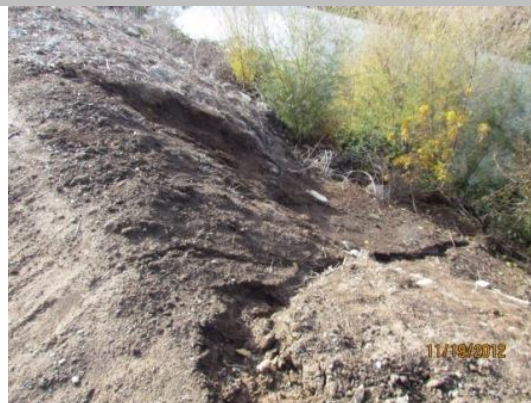
Photo 1 of 2 : FA_2017_NA0017_160_230_20171016_00146.jpg

LM Start	3.53	Rating **	A/W	Issue No.	230
LM End	3.53	Issue Type +	Ma	Location *	WS
Category	Earthen Levee			GPS Latitude/Longitude	
				Start	End
Item	Erosion / Bank Caving			38.020433 °	38.020433 °
				-121.061867 °	-121.061867 °
DWR ID	DWR_NA0017_16_f_2012_230				
Comment Code					
E2 : Schedule repair of erosion site prior to the next inspection.					
Inspector Comment					
This portion of the levee is non-project. Therefore, an A/W rating was given.

Slope instability was found on the waterside slope of the levee looking downstream.

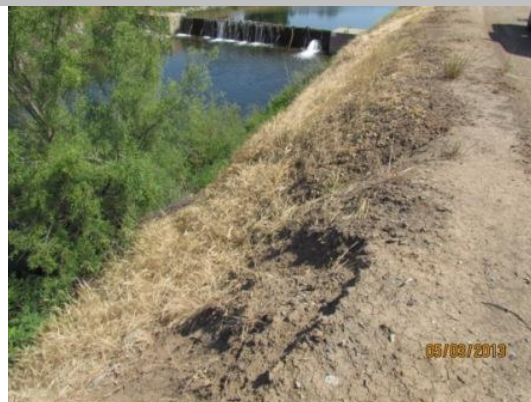
Photo 2 of 2 : FA_2017_NA0017_160_230_20171016_00147.jpg

LM Start	3.53	Rating **	A/W	Issue No.	230 (cont)
LM End	3.53	Issue Type +	Ma	Location *	WS

Erosion was found on the waterside slope of the levee looking upstream.

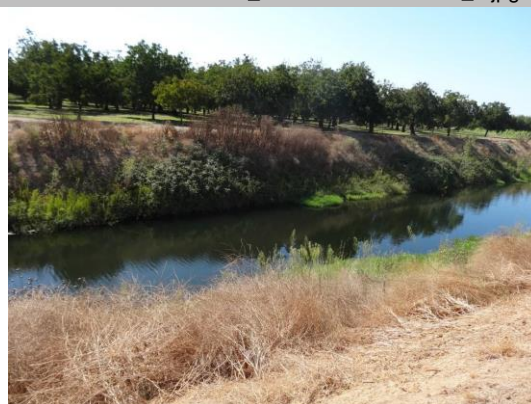
Photo 1 of 4 : SJR2017_NA0017U16RM19.29_1.jpg

LM Start	3.61	Rating **	M	Issue No.	54
LM End	3.61	Issue Type +	Ma	Location *	WS
Category	Supplemental			GPS Latitude/Longitude	
				Start	End
Item	DWR Erosion Survey			38.019642 °	38.019642 °
				-121.062917 °	-121.062917 °
DWR ID	NA0017U16RM19.29				
Comment Code					
Inspector Comment					
08/30/2017: No significant change observed.					
08/16/2016: No significant change observed.					
08/12/2015: No significant change observed.					
08/20/2014: A pocket erosion was found near the water's edge. [2017					
Site ID:NA0017U16RM19.29]

View of the site from right river bank.

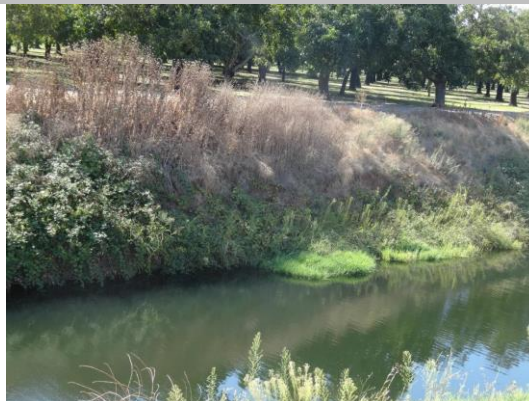
Photo 2 of 4 : SJR2017_NA0017U16RM19.29_2.jpg

Close view of the erosion.

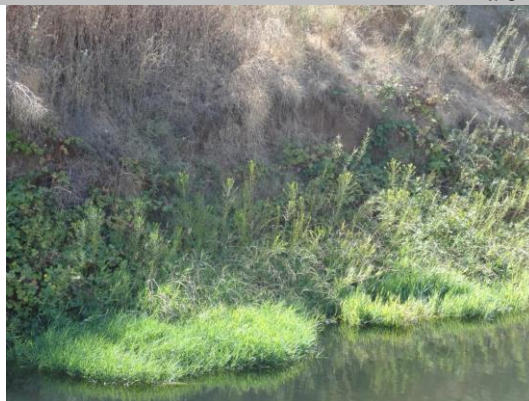
Photo 3 of 4 : SJR2017_NA0017U16RM19.29_3.jpg

Close view of the erosion. Note the dense vegetation at the site.

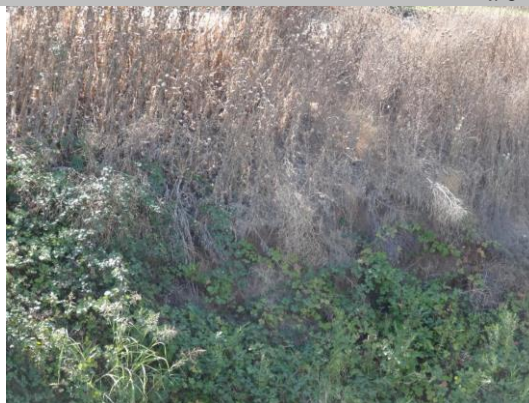
Photo 4 of 4 : SJR2017_NA0017U16RM19.29_4.jpg

Close view of the site.

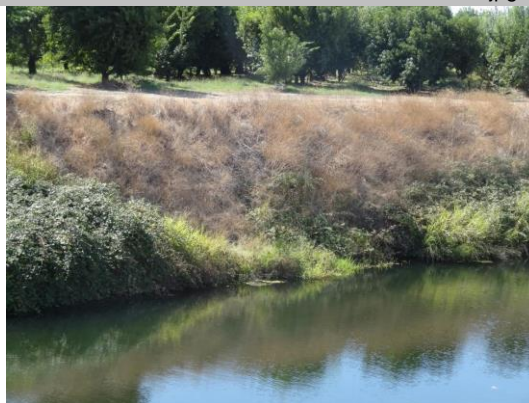
Photo 1 of 4 : SJR2017_NA0017U16RM19.18_1.jpg

LM Start	3.78	Rating **	M	Issue No.	49
LM End	3.80	Issue Type +	Ma	Location *	WS
Category	Supplemental			GPS Latitude/Longitude	
				Start	End
Item	DWR Erosion Survey			38.017715 °	38.017715 °
				-121.065011 °	-121.065011 °
DWR ID	NA0017U16RM19.18				
Comment Code					
Inspector Comment					
08/30/2017: No significant change observed.					
08/16/2016: No significant change observed at the erosion. More vegetation observed at the site.					
08/12/2015: No significant change observed.					
08/20/2014: No significant change observed.					
09/12/2013: No significant change observed.					
08/22/2012: River-induced erosion occurred on the berm, while the runoff-induced erosion occurred on the levee slope. Site is covered with vegetation. There is no levee structure on site. The levee crest width and levee height were not measured or estimated in the field. [2017 Site ID:NA0017U16RM19.18]

View of the site from right river bank.

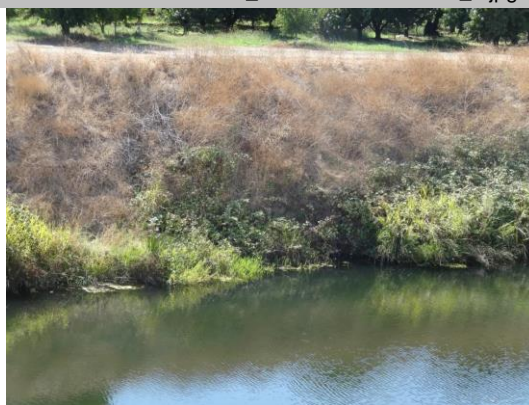
Photo 2 of 4 : SJR2017_NA0017U16RM19.18_2.jpg

Close view of the erosion.

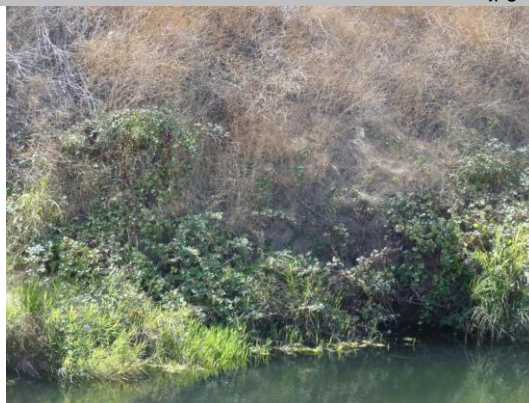
Photo 3 of 4 : SJR2017_NA0017U16RM19.18_3.jpg

Comment Code					
Inspector Comment					
08/30/2017: No significant change observed.					
08/16/2016: No significant change observed at the erosion. More vegetation observed at the site.					
08/12/2015: No significant change observed.					
08/20/2014: No significant change observed.					
09/12/2013: No significant change observed.					
08/22/2012: River-induced erosion occurred on the berm, while the runoff-induced erosion occurred on the levee slope. Site is covered with vegetation. There is no levee structure on site. The levee crest width and levee height were not measured or estimated in the field. [2017 Site ID:NA0017U16RM19.18]

Front view of the erosion at the berm.

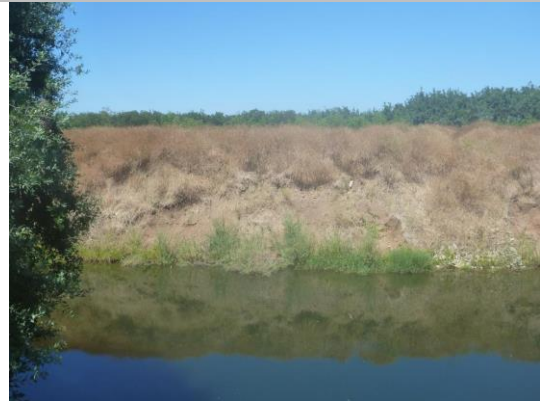
Photo 3 of 3 : LEVAL_FA_2017_475_2260.jpg

Comment Code					
Inspector Comment					
Levee Evaluation Comments					
Description:Erosion is on the waterside slope; The lat, long above are from the Spring DWR inspection report which took the photo and GPS from the right bank. The erosion is on the left bank.					
Site ID No:475					
Site Designation:LMA-302					
Repair Type: Erosion					
Rating:Area of Concern					
Field Date:7/27/2017					
Notes: Small levee prism which turns into high ground nearby. Very dense vegetation on crown (5 ft tall). Opposite bank is lower than the eroded levee and is designed to flood the nearby orchard. This is thought to be caused by a beaver den and has been cited in past 2 DWR inspections.

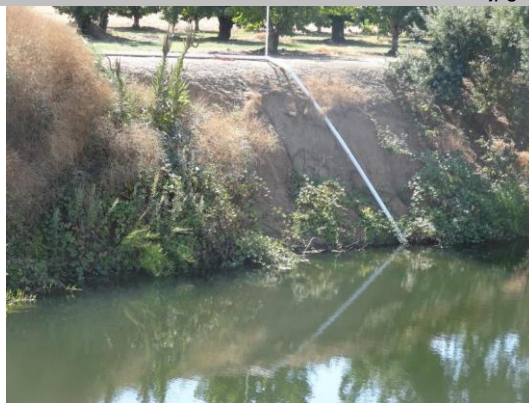
Photo 2 of 4 : SJR2017_NA0017U16RM18.69_2.jpg

LM Start	4.16	Rating **	U	Issue No.	47 (cont)	
LM End	4.18	Issue Type +	Ma	Location *	WS	
Category	Supplemental			GPS Latitude/Longitude		
				Start		End
Item	DWR Erosion Survey			38.012792 °		38.012792 °
				-121.068073 °		-121.068073 °
DWR ID	NA0017U16RM18.69					
Comment Code						
Inspector Comment						
08/30/2017: New erosion observed at the site, under the irrigation pipe.						
08/16/2016: No significant change observed.						
08/12/2015: No significant change observed.						
08/20/2014: No significant change observed.						
09/12/2013: No significant change observed.						
08/22/2012: An irrigation pipe is present at the site, but probably did not cause the erosion. There is no levee structure on site. The levee crest width and levee height were not measured or estimated in the field.						
[2017 Site ID:NA0017U16RM18.69]

View of the new erosion erosion under the irrigation pipe.

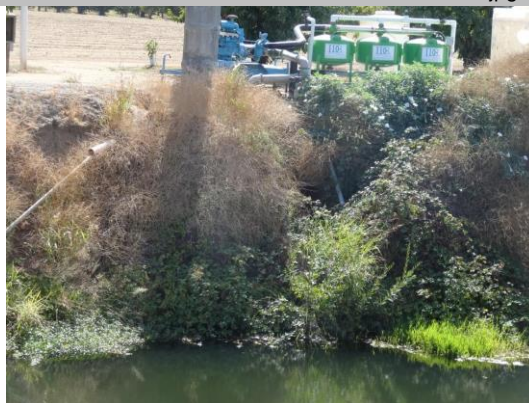
Photo 3 of 4 : SJR2017_NA0017U16RM18.69_3.jpg

Close view of the erosion.

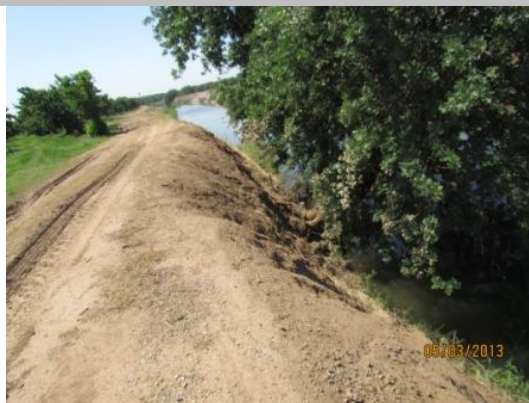
Photo 2 of 2 : FA_2017_NA0017_160_228_20171016_00145.jpg

LM Start	4.20	Rating **	A/W	Issue No.	228 (cont)	
LM End	4.20	Issue Type +	Ma	Location *	WS	
Category	Earthen Levee			GPS Latitude/Longitude		
				Start		End
Item	Slope Stability			38.012288 °		38.012288 °
				-121.068239 °		-121.068239 °
DWR ID	DWR_NA0017_16_f_2012_228					
Comment Code						
S1 : Repair slope instability.						
Inspector Comment						
This portion of the levee is non-project. Therefore, an A/W rating was given.

Slope instability was found on the waterside shoulder of the levee looking downstream.

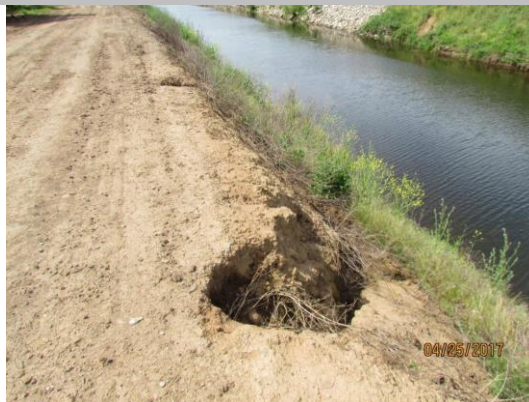
Photo 1 of 2 : FA_2017_NA0017_160_73_20171016_00072.jpg

LM Start	4.27	Rating **	A/W	Issue No.	73
LM End	4.27	Issue Type +	Ma	Location *	WS
Category	Earthen Levee			GPS Latitude/Longitude	
				Start	End
Item	Erosion / Bank Caving			38.011288 °	38.011288 °
				-121.068579 °	-121.068579 °
DWR ID	DWR_NA0017_16_s_2013_73				
Comment Code					
E2 : Schedule repair of erosion site prior to the next inspection.					
Inspector Comment					
The erosion may cut into the access road if it is not repaired.

Updated picture of the erosion on the waterside of the levee. Spring 2017

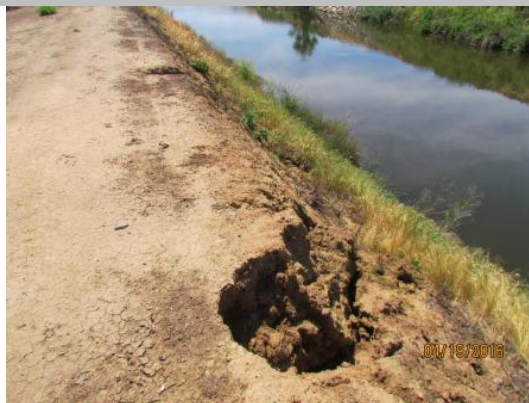
Photo 2 of 2 : FA_2017_NA0017_160_73_20171016_00073.jpg

View of the erosion on the waterside shoulder of the levee during spring 2016 inspection.

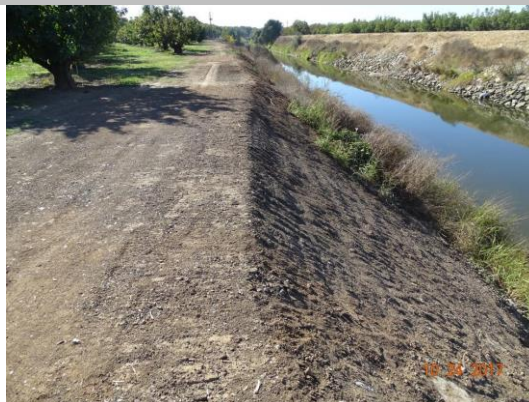
Photo 1 of 2 : FA_2017_NA0017_160_278_20171027_00434.jpg

LM Start	4.30	Rating **	A	Issue No.	278
LM End	4.30	Issue Type +	Ma	Location *	WS
Category	Earthen Levee			GPS Latitude/Longitude	
				Start	End
Item	Erosion / Bank Caving			38.010918 °	38.010918 °
				-121.068686 °	-121.068686 °
DWR ID	DWR_NA0017_16_s_2017_278				
Comment Code					
E1 : Note and monitor erosion site.					
Inspector Comment					
LMA repaired the erosion at this location.

LMA has repaired the erosion on the waterside shoulder of the levee. Fall 2017

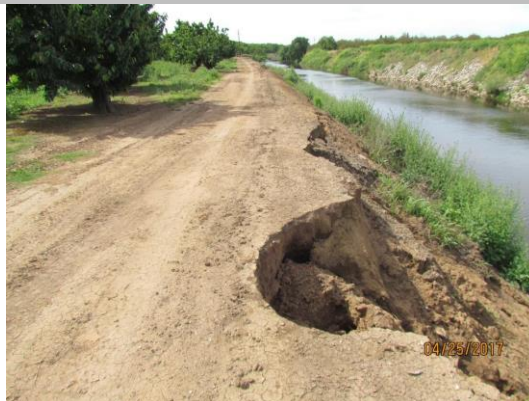
Photo 2 of 2 : FA_2017_NA0017_160_278_20171016_00184.jpg

View of the erosion on the waterside shoulder of the levee. Spring 2017

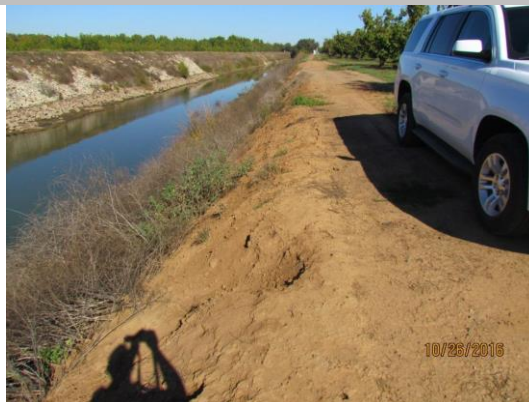
Photo 1 of 1 : FA_2017_NA0017_160_243_20171016_00151.jpg

LM Start	4.38	Rating **	A/W	Issue No.	243
LM End	4.38	Issue Type +	Ma	Location *	WS
Category	Earthen Levee			GPS Latitude/Longitude	
				Start	End
Item	Erosion / Bank Caving			38.009861 °	38.009861 °
				-121.069021 °	-121.069021 °
DWR ID	DWR_NA0017_16_f_2016_243				
Comment Code					
E2 : Schedule repair of erosion site prior to the next inspection.					
Inspector Comment					
The erosion may cut into the access road if it is not repaired.

View of the erosion on the waterside slope of the levee. Fall 2016

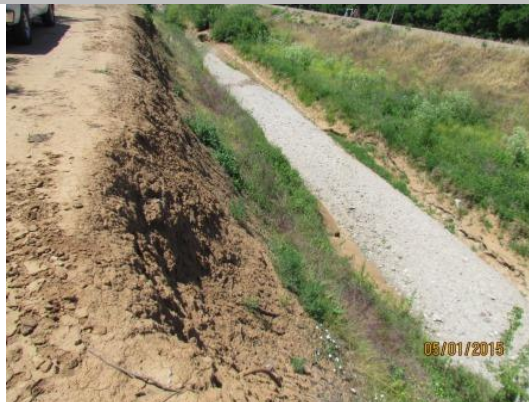
Photo 1 of 1 : FA_2017_NA0017_160_245_20171016_00152.jpg

LM Start	4.85	Rating **	A/W	Issue No.	245
LM End	4.85	Issue Type +	Ma	Location *	WS
Category	Earthen Levee			GPS Latitude/Longitude	
				Start	End
Item	Erosion / Bank Caving			38.003673 °	38.003673 °
				-121.072496 °	-121.072496 °
DWR ID	DWR_NA0017_16_s_2015_245				
Comment Code					
E1 : Note and monitor erosion site.					
Inspector Comment					
Observe to make sure the erosion doesn't cut into the access road.

View of erosion on the waterside slope of the levee looking downstream.

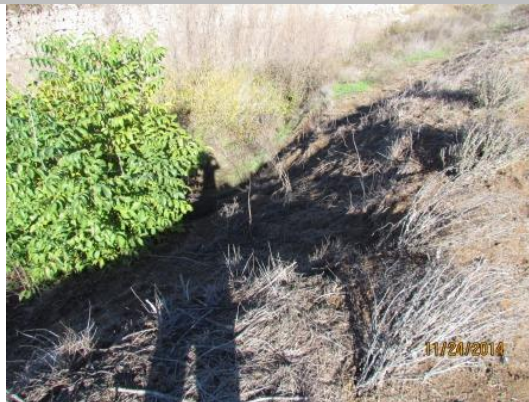
Photo 1 of 1 : FA_2017_NA0017_160_265_20171016_00169.jpg

LM Start	5.20	Rating **	A/W	Issue No.	265
LM End	5.20	Issue Type +	Ma	Location *	WS
Category	Earthen Levee			GPS Latitude/Longitude	
				Start	End
Item	Slope Stability			37.999537 °	37.999537 °
				-121.076133 °	-121.076133 °
DWR ID	DWR_NA0017_16_f_2014_265				
Comment Code					
S1 : Repair slope instability.					
Inspector Comment					
This portion of the levee is non-project. Therefore, an A/W rating was given.

A slope instability was found on the waterside slope of the levee looking upstream.

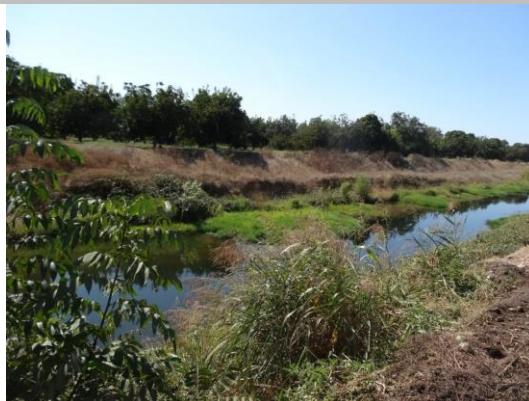
Photo 1 of 4 : SJR2017_NA0017U16RM17.81_1.jpg

LM Start	5.33	Rating **	M	Issue No.	42
LM End	5.38	Issue Type +	Ma	Location *	WS
Category	Supplemental			GPS Latitude/Longitude	
				Start	End
Item	DWR Erosion Survey			37.997720 °	37.997720 °
				-121.077807 °	-121.077807 °
DWR ID	NA0017U16RM17.81				
Comment Code					
Inspector Comment					
08/30/2017: No significant change observed.					
08/16/2016: No significant change observed.					
08/12/2015: No significant change observed.					
08/20/2014: No significant change observed.					
09/12/2013: No significant change observed.					
08/22/2012: The site is located at the opposite river bank of E. Tobacco Road. There is no levee structure on site. The levee crest width and levee height were not measured or estimated in the field. [2017 Site ID:NA0017U16RM17.81]

Upstream view of the site from right river bank.

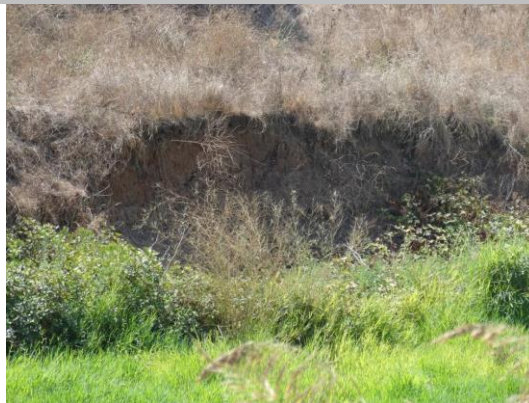
Photo 3 of 4 : SJR2017_NA0017U16RM17.81_3.jpg

LM Start	5.33	Rating **	M	Issue No.	42 (cont)	
LM End	5.38	Issue Type +	Ma	Location *	WS	
Category	Supplemental			GPS Latitude/Longitude		
				Start	End	
Item	DWR Erosion Survey			37.997720 °	37.997720 °	
				-121.077807 °	-121.077807 °	
DWR ID	NA0017U16RM17.81					
Comment Code						
Inspector Comment						
08/30/2017: No significant change observed.						
08/16/2016: No significant change observed.						
08/12/2015: No significant change observed.						
08/20/2014: No significant change observed.						
09/12/2013: No significant change observed.						
08/22/2012: The site is located at the opposite river bank of E. Tobacco Road. There is no levee structure on site. The levee crest width and levee height were not measured or estimated in the field. [2017 Site ID:NA0017U16RM17.81]

Close view of the erosion.

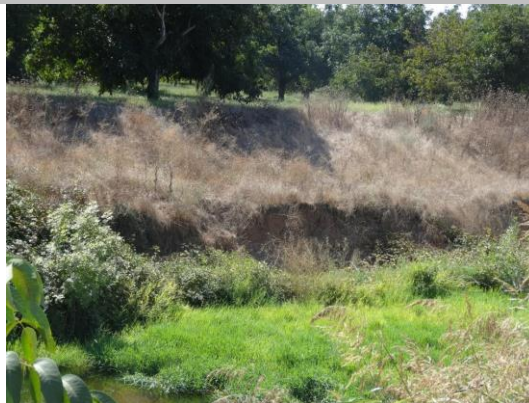
Photo 4 of 4 : SJR2017_NA0017U16RM17.81_4.jpg

Close view of the erosion.

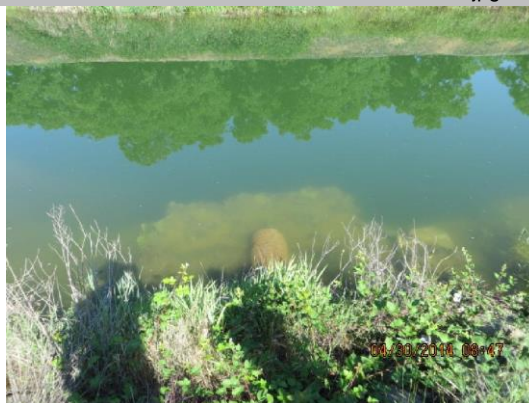
Photo 1 of 3 : UCIP_FA_2017_35686_64327.jpg

LM Start	5.48	Rating **	M	Issue No.	814
LM End	5.48	Issue Type +	Ma	Location *	
Category	Supplemental			GPS Latitude/Longitude	
				Start	End
Item	DWR UCIP LMA Responsibility			37.996132 °	37.996132 °
				-121.079127 °	-121.079127 °
DWR ID					
Comment Code					
Inspector Comment					
FS_ID:35686 DS_ID:23332 EP_NO: N/A Repair Type: Non-Urgent Crossing Status: Found UCIP Comments: Pipe appears abandoned and if so should be done so properly. LS of pipe is burried and WS is badly rusted. Pipe should be inspected internally. FIELD_STRUCT_DESC: *ABANDONED* 18-inch corrugated metal drainage pipe through the levee, 3 feet below the crown. Grout over pipe in channel with pipe open and visible in water at the WS toe. [Additional Reference(s): DWR Levee Log, 1992. USACE San Joaquin O&M Manual 611.1, Volume F, (HLM 5.69)]. FS Date: 4/30/2014

Pipe visible in water at WS toe.

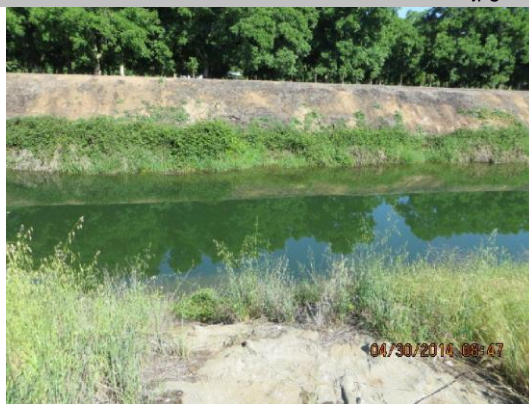
Photo 2 of 3 : UCIP_FA_2017_35686_64326.jpg

Grout over pipe in channel on WS.

Comment Code						
Inspector Comment						
FS_ID:35686						
DS_ID:23332						
EP_NO: N/A						
Repair Type: Non-Urgent						
Crossing Status: Found						
UCIP Comments: Pipe appears abandoned and if so should be done so properly. LS of pipe is burried and WS is badly rusted. Pipe should be inspected internally.						
FIELD_STRUCT_DESC: *ABANDONED* 18-inch corrugated metal drainage pipe through the levee, 3 feet below the crown. Grout over pipe in channel with pipe open and visible in water at the WS toe.						
[Additional Reference(s): DWR Levee Log, 1992. USACE San Joaquin O&M Manual 611.1, Volume F, (HLM 5.69)].						
FS Date: 4/30/2014

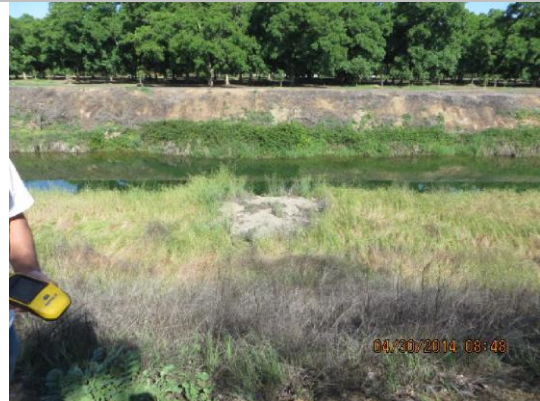
Photo 3 of 3 : UCIP_FA_2017_35686_64325.jpg

Grout over pipe in channel on WS.

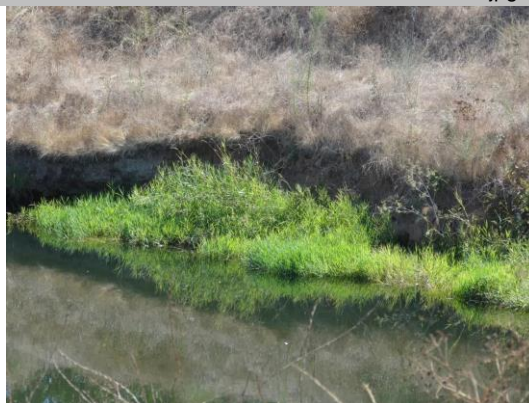
Photo 2 of 4 : SJR2017_NA0017U16RM17.27_2.jpg

LM Start	5.56	Rating **	U	Issue No.	41 (cont)
LM End	5.58	Issue Type +	Ma	Location *	WS
Category	Supplemental			GPS Latitude/Longitude	
				Start	End
Item	DWR Erosion Survey			37.995216 °	37.995216 °
				-121.080159 °	-121.080159 °
DWR ID	NA0017U16RM17.27				
Comment Code					
Inspector Comment					
08/30/2017: No significant change observed. 08/16/2016: No significant change observed. 08/12/2015: No significant change observed. 08/20/2014: No significant change observed. 09/12/2013: The erosion seems to be caused by high river flow. Dense vegetation is present at the site. Signs of animal activities are visible. There is no levee structure on site. The levee crest width and levee height were not measured or estimated in the field. [2017 Site ID:NA0017U16RM17.27]

Close view of the erosion site.

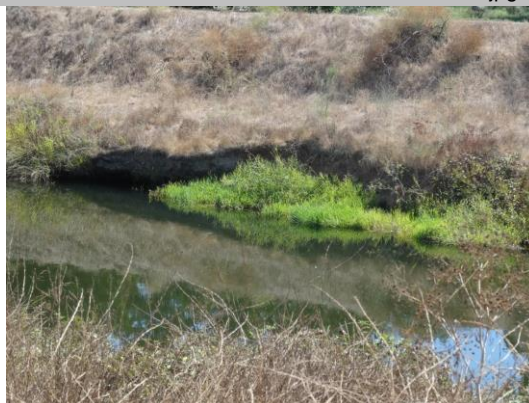
Photo 3 of 4 : SJR2017_NA0017U16RM17.27_3.jpg

Close view of the erosion.

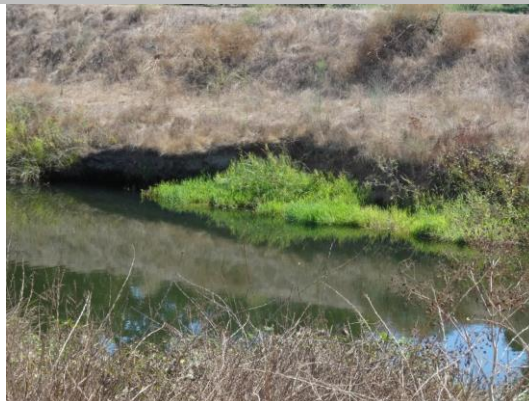
Photo 4 of 4 : SJR2017_NA0017U16RM17.27_4.jpg

LM Start	5.56	Rating **	U	Issue No.	41 (cont)
LM End	5.58	Issue Type +	Ma	Location *	WS
Category	Supplemental			GPS Latitude/Longitude	
				Start	End
Item	DWR Erosion Survey			37.995216 °	37.995216 °
				-121.080159 °	-121.080159 °
DWR ID	NA0017U16RM17.27				
Comment Code					
Inspector Comment					
08/30/2017: No significant change observed.					
08/16/2016: No significant change observed.					
08/12/2015: No significant change observed.					
08/20/2014: No significant change observed.					
09/12/2013: The erosion seems to be caused by high river flow. Dense vegetation is present at the site. Signs of animal activities are visible. There is no levee structure on site. The levee crest width and levee height were not measured or estimated in the field. [2017 Site ID:NA0017U16RM17.27]

Close view of the erosion.

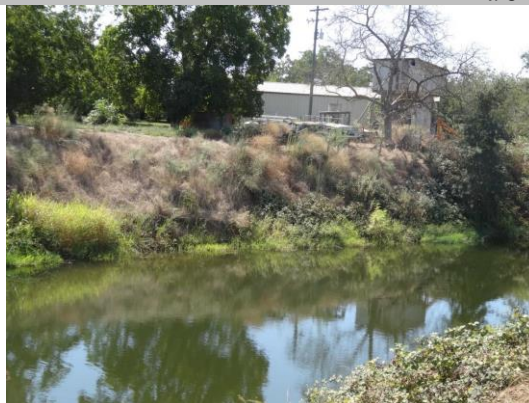
Photo 1 of 4 : SJR2017_NA0017U16RM17.11_1.jpg

LM Start	5.71	Rating **	M	Issue No.	40
LM End	5.72	Issue Type +	Ma	Location *	WS
Category	Supplemental			GPS Latitude/Longitude	
				Start	End
Item	DWR Erosion Survey			37.993525 °	37.993525 °
				-121.081679 °	-121.081679 °
DWR ID	NA0017U16RM17.11				
Comment Code					
Inspector Comment					
08/30/2017: No significant change observed.					
08/16/2016: No significant change observed.					
08/12/2015: No significant change observed.					
08/20/2014: The erosion is near a tree and probably has been made worse by the unstable bank slope. [2017 Site ID:NA0017U16RM17.11]

View of the site from right river bank.

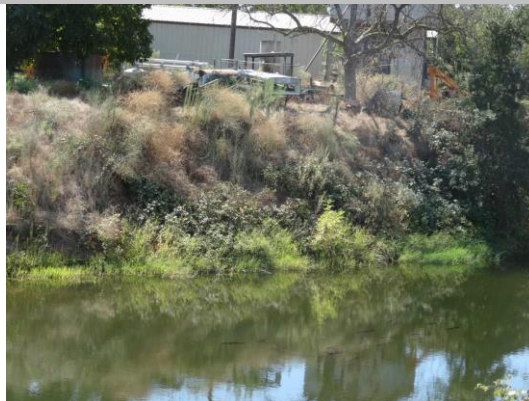
Photo 2 of 4 : SJR2017_NA0017U16RM17.11_2.jpg

LM Start	5.71	Rating **	M	Issue No.	40 (cont)
LM End	5.72	Issue Type +	Ma	Location *	WS
Category	Supplemental			GPS Latitude/Longitude	
				Start	End
Item	DWR Erosion Survey			37.993525 °	37.993525 °
				-121.081679 °	-121.081679 °
DWR ID	NA0017U16RM17.11				
Comment Code					
Inspector Comment					
08/30/2017: No significant change observed.					
08/16/2016: No significant change observed.					
08/12/2015: No significant change observed.					
08/20/2014: The erosion is near a tree and probably has been made worse by the unstable bank slope. [2017 Site ID:NA0017U16RM17.11]

Close view of the erosion.

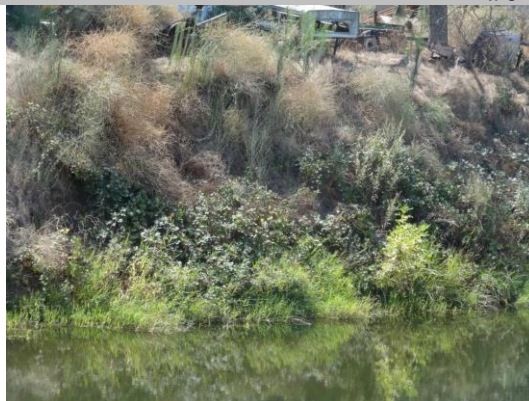
Photo 3 of 4 : SJR2017_NA0017U16RM17.11_3.jpg

Close view of the erosion.

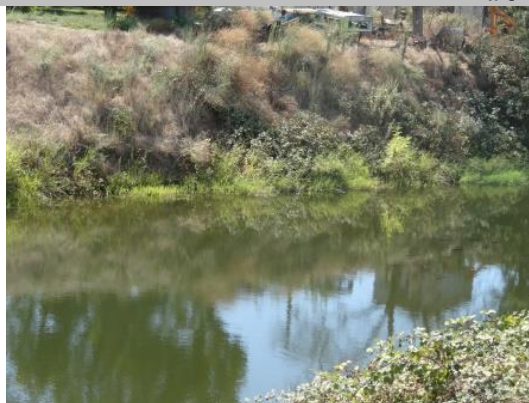
Photo 4 of 4 : SJR2017_NA0017U16RM17.11_4.jpg

Close view of the erosion.

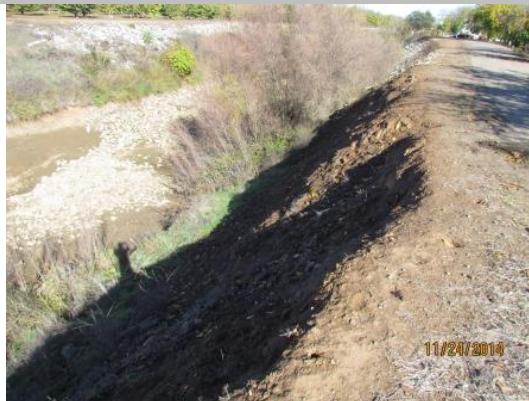
Photo 1 of 1 : FA_2017_NA0017_160_264_20171016_00168.jpg

LM Start	5.87	Rating **	A/W	Issue No.	264
LM End	5.87	Issue Type +	Ma	Location *	WS
Category	Earthen Levee			GPS Latitude/Longitude	
				Start	End
Item	Slope Stability			37.991628 °	37.991628 °
				-121.083312 °	-121.083312 °
DWR ID	DWR_NA0017_16_f_2014_264				
Comment Code					
S1 : Repair slope instability.					
Inspector Comment					
This portion of the levee is non-project. Therefore, an A/W rating was given.

A slope instability was found on the waterside of the levee looking upstream.

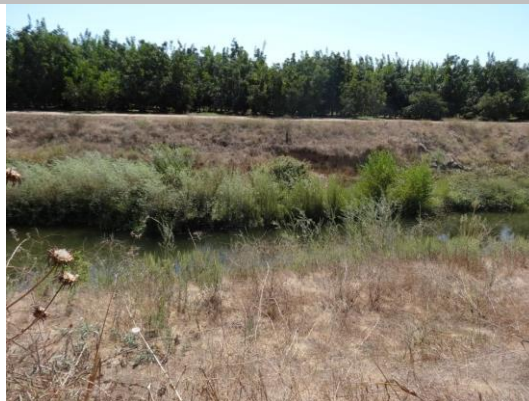
Photo 1 of 4 : SJR2017_NA0017U16RM16.27_1.jpg

LM Start	6.49	Rating **	U	Issue No.	39
LM End	6.68	Issue Type +	Ma	Location *	WS
Category	Supplemental			GPS Latitude/Longitude	
				Start	End
Item	DWR Erosion Survey			37.983279 °	37.983279 °
				-121.090843 °	-121.090843 °
DWR ID	NA0017U16RM16.27				
Comment Code					
Inspector Comment					
08/30/2017: No significant change observed.					
08/16/2016: No significant change observed.					
08/12/2015: No significant change observed.					
08/20/2014: No significant change observed.					
09/12/2013: Site has been surveyed and the erosion has worsened since last year.					
08/22/2012: Discontinuous scarp or pocket erosions occurred along a long stretch of the river, with an erosion height greater than 25 ft. at certain points. There is no levee structure on site. The levee crest width and levee height were not measured or estimated in the field. [2017 Site ID:NA0017U16RM16.27]

Upstream view of the site from right river bank.

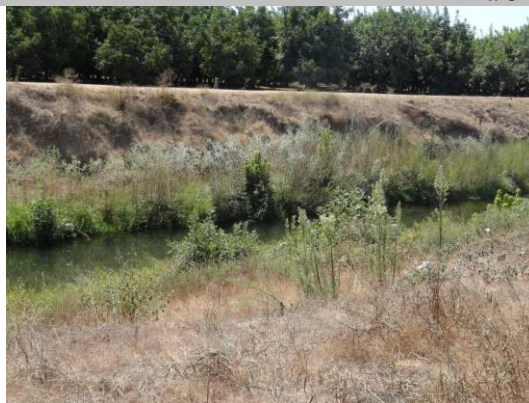
Photo 2 of 4 : SJR2017_NA0017U16RM16.27_2.jpg

Close view of the erosion.

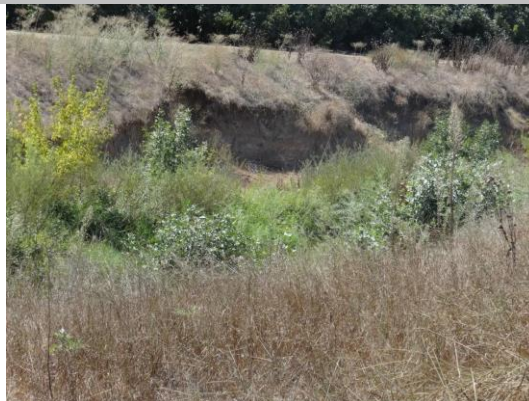
Photo 3 of 4 : SJR2017_NA0017U16RM16.27_3.jpg

Comment Code						
Inspector Comment						
08/30/2017: No significant change observed.						
08/16/2016: No significant change observed.						
08/12/2015: No significant change observed.						
08/20/2014: No significant change observed.						
09/12/2013: Site has been surveyed and the erosion has worsened since last year.						
08/22/2012: Discontinuous scarp or pocket erosions occurred along a long stretch of the river, with an erosion height greater than 25 ft. at certain points. There is no levee structure on site. The levee crest width and levee height were not measured or estimated in the field. [2017 Site ID:NA0017U16RM16.27]

Front view of the erosion.

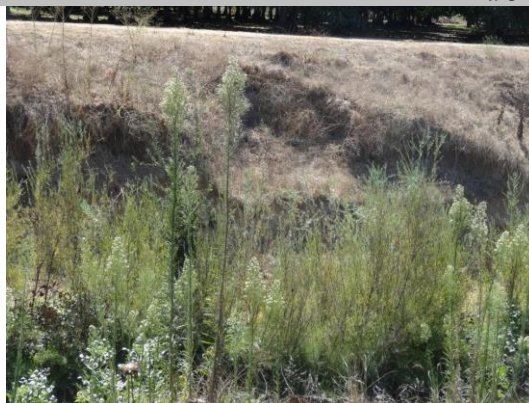
Photo 4 of 4 : SJR2017_NA0017U16RM16.27_4.jpg

Close view of the erosion.

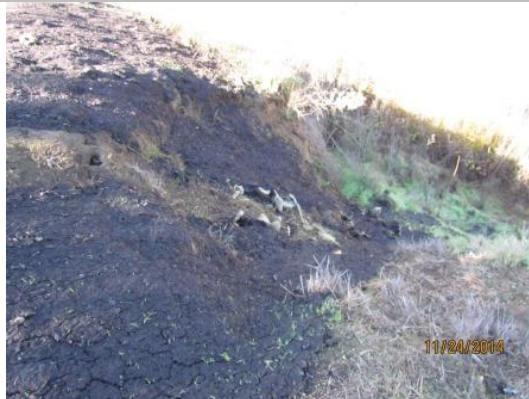
Photo 1 of 2 : FA_2017_NA0017_160_120_20171016_00107.jpg

LM Start	6.70	Rating **	A/W	Issue No.	120
LM End	6.70	Issue Type +	Ma	Location *	WS
Category	Earthen Levee			GPS Latitude/Longitude	
				Start	End
Item	Slope Stability			37.982299 °	37.982299 °
				-121.092665 °	-121.092665 °
DWR ID	DWR_NA0017_16_s_2014_120				
Comment Code					
S1 : Repair slope instability.					
Inspector Comment					
This portion of the levee is non-project. Therefore, an A/W rating was given.

Updated picture of the slope instability on the waterside of the levee looking downstream.

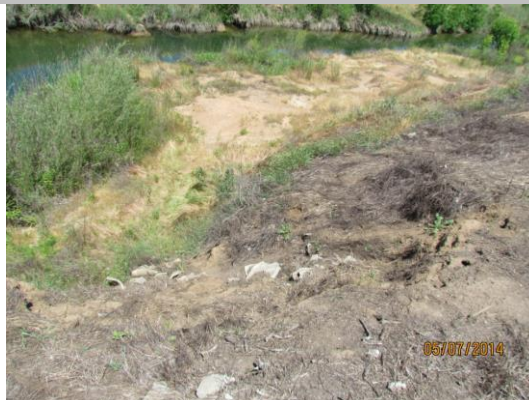
Photo 2 of 2 : FA_2017_NA0017_160_120_20171016_00108.jpg

Slope instability was found on the waterside of the levee looking upstream.

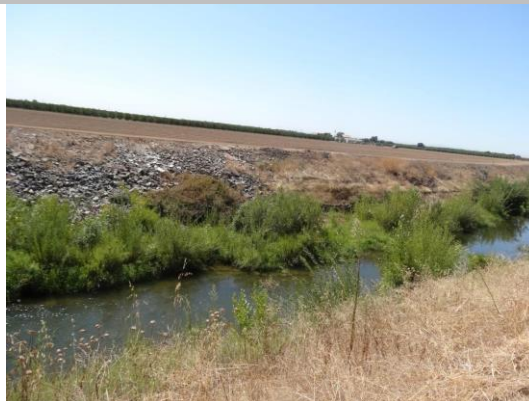
Photo 1 of 4 : SJR2017_NA0017U16RM15.57_1.jpg

08/30/2017: No significant change observed.
 08/16/2016: No significant change observed.
 08/12/2015: No significant change observed.
 08/20/2014: No significant change observed. Note the site ID changed from NA0017U16RM10.82 to NA0017U16RM15.57 to reflect the correct river mile.
 09/12/2013: The site is located at immediately downstream of a levee segment protected by broken concrete. There is no levee structure on site. The levee crest width and levee height were not measured or estimated in the field. [2017 Site ID:NA0017U16RM15.57]

View of the site from right river bank.

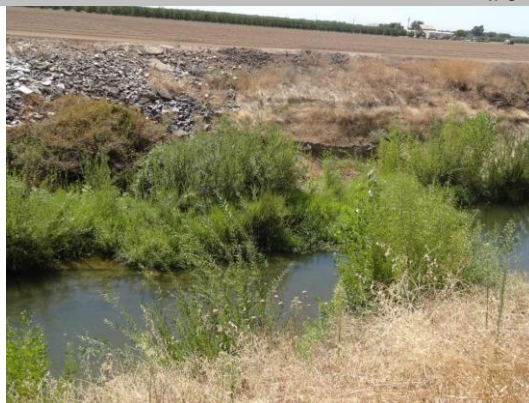
Photo 2 of 4 : SJR2017_NA0017U16RM15.57_2.jpg

Close view of the erosion.

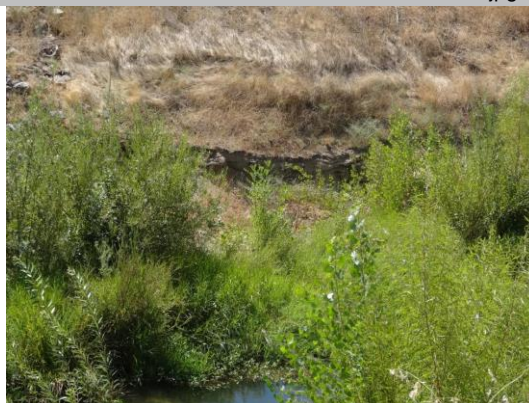
Photo 3 of 4 : SJR2017_NA0017U16RM15.57_3.jpg

08/30/2017: No significant change observed.
 08/16/2016: No significant change observed.
 08/12/2015: No significant change observed.
 08/20/2014: No significant change observed. Note the site ID changed from NA0017U16RM10.82 to NA0017U16RM15.57 to reflect the correct river mile.
 09/12/2013: The site is located at immediately downstream of a levee segment protected by broken concrete. There is no levee structure on site. The levee crest width and levee height were not measured or estimated in the field. [2017 Site ID:NA0017U16RM15.57]

Close view of the erosion.

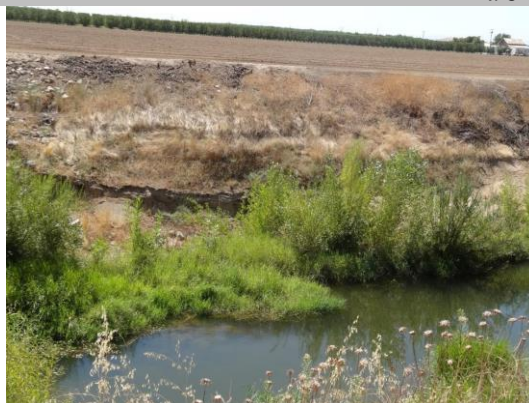
Photo 4 of 4 : SJR2017_NA0017U16RM15.57_4.jpg

Close view of the erosion.

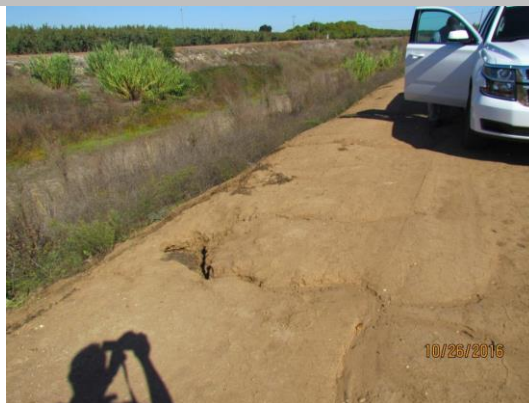
Photo 1 of 2 : FA_2017_NA0017_160_275_20171016_00179.jpg

LM Start	7.84	Rating **	A/W	Issue No.	275
LM End	7.84	Issue Type +	Ma	Location *	WS
Category	Earthen Levee			GPS Latitude/Longitude	
				Start	End
Item	Erosion / Bank Caving			37.973620 °	37.973620 °
				-121.109680 °	-121.109680 °
DWR ID	DWR_NA0017_16_s_2016_275				
Comment Code					
E2 : Schedule repair of erosion site prior to the next inspection.					
Inspector Comment					
Erosion may cut into the access road.

View of the erosion caused by rodent holes on the waterside shoulder of the levee looking upstream. Fall 2016

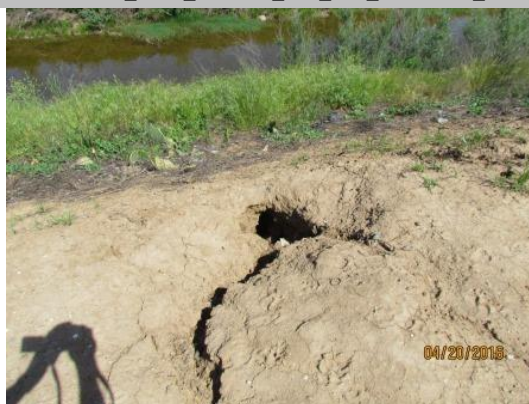
Photo 2 of 2 : FA_2017_NA0017_160_275_20171016_00180.jpg

View of a rodent hole on the waterside shoulder of the levee.

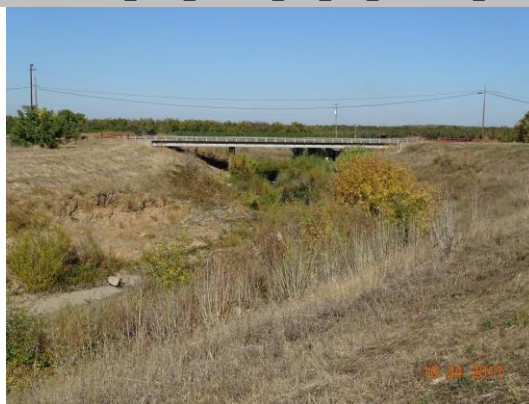
Photo 1 of 1 : FA_2017_NA0017_160_255_20171027_00435.jpg

LM Start	8.17	Rating **	M	Issue No.	255
LM End	8.17	Issue Type +	Ma	Location *	
Category	Rivers, Channels & Designated Floodways			GPS Latitude/Longitude	
				Start	End
Item	Vegetation & Obstructions			37.970427 °	37.970427 °
				-121.113623 °	-121.113623 °
DWR ID	DWR_NA0017_16_f_2017_255				
Comment Code					
Inspector Comment					
Woody vegetation may impede the flow of the channel at this location.

View of woody vegetation on the channel looking upstream. Fall 2017

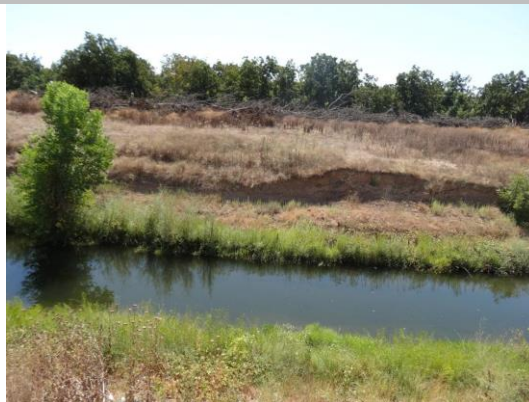
Photo 1 of 4 : SJR2017_NA0017U16RM14.48_1.jpg

08/30/2017: No significant change observed.
 08/16/2016: No significant change observed.
 08/12/2015: No significant change observed.
 08/20/2014: No significant change observed.
 09/12/2013: No significant change observed.
 08/22/2012: The erosion occurred on a berm of approximately 25 ft. wide. Site is covered with dense vegetation. There is no levee structure on site. The levee crest width and levee height were not measured or estimated in the field. [2017 Site ID:NA0017U16RM14.48]

View of the site from right river bank.

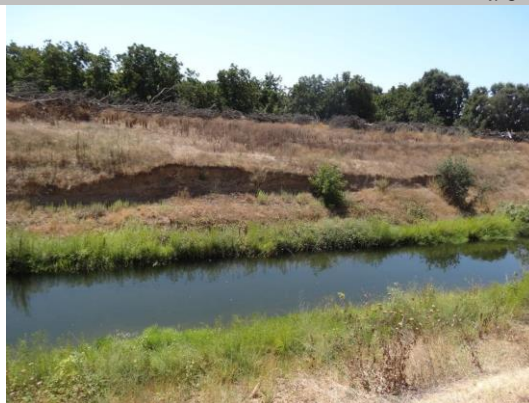
Photo 2 of 4 : SJR2017_NA0017U16RM14.48_2.jpg

Front view of the erosion.

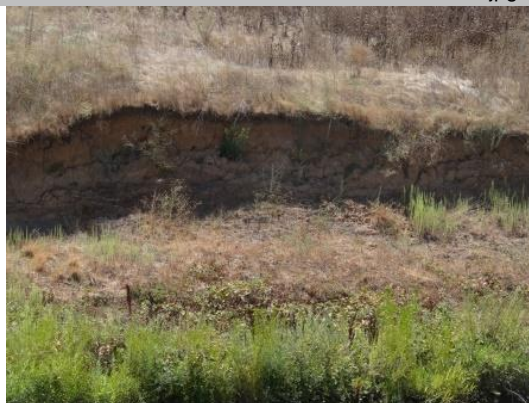
Photo 3 of 4 : SJR2017_NA0017U16RM14.48_3.jpg

08/30/2017: No significant change observed.
 08/16/2016: No significant change observed.
 08/12/2015: No significant change observed.
 08/20/2014: No significant change observed.
 09/12/2013: No significant change observed.
 08/22/2012: The erosion occurred on a berm of approximately 25 ft. wide. Site is covered with dense vegetation. There is no levee structure on site. The levee crest width and levee height were not measured or estimated in the field. [2017 Site ID:NA0017U16RM14.48]

Close view of the erosion.

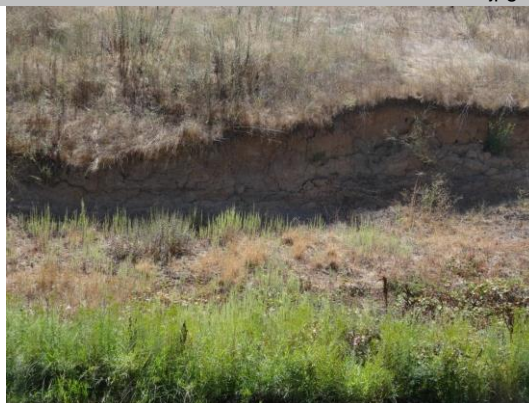
Photo 4 of 4 : SJR2017_NA0017U16RM14.48_4.jpg

Close view of the erosion.

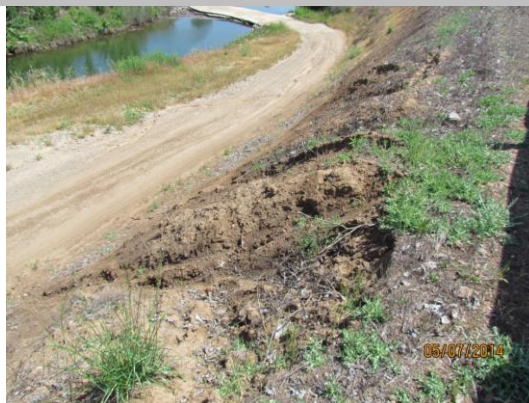
Photo 1 of 2 : FA_2017_NA0017_160_128_20171016_00113.jpg

LM Start	8.60	Rating **	A/W	Issue No.	128
LM End	8.60	Issue Type +	Ma	Location *	WS
Category	Earthen Levee			GPS Latitude/Longitude	
				Start	End
Item	Slope Stability			37.968157 °	37.968157 °
				-121.120620 °	-121.120620 °
DWR ID	DWR_NA0017_16_s_2013_128				
Comment Code					
S1 : Repair slope instability.					
Inspector Comment					
This portion of the levee is non-project. Therefore, an A/W rating was given.

Updated picture of the slope instability on the waterside of the levee looking upstream during spring 2014 inspection.

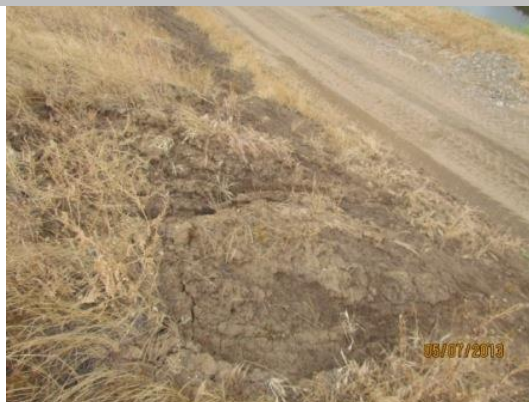
Slope instability was found on the waterside slope of the levee looking downstream.

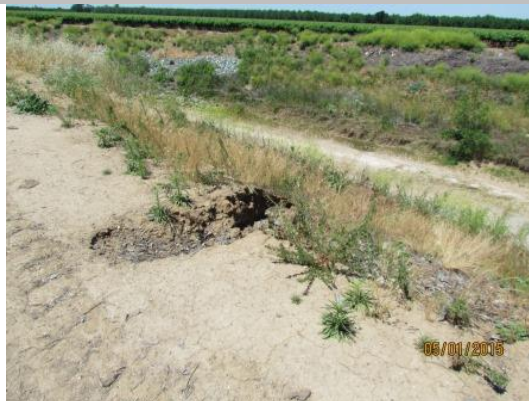
Photo 1 of 1 : FA_2017_NA0017_160_248_20171016_00155.jpg

LM Start	8.68	Rating **	A/W	Issue No.	248
LM End	8.68	Issue Type +	Ma	Location *	WS
Category	Earthen Levee			GPS Latitude/Longitude	
				Start	End
Item	Erosion / Bank Caving			37.968169 °	37.968169 °
				-121.122047 °	-121.122047 °
DWR ID	DWR_NA0017_16_s_2015_248				
Comment Code					
E1 : Note and monitor erosion site.					
Inspector Comment					
Erosion may cut into the access road.

Erosion was found on the waterside looking downstream.

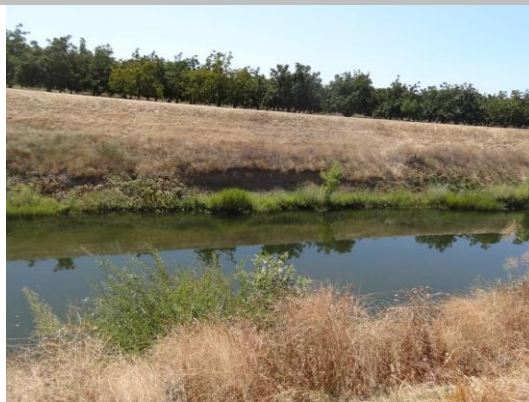
Photo 1 of 4 : SJR2017_NA0017U16RM13.86_1.jpg

LM Start	9.00	Rating **	M	Issue No.	36
LM End	9.00	Issue Type +	Ma	Location *	WS
Category	Supplemental			GPS Latitude/Longitude	
				Start	End
Item	DWR Erosion Survey			37.966615 °	37.966615 °
				-121.127328 °	-121.127328 °
DWR ID	NA0017U16RM13.86				
Comment Code					
Inspector Comment					
08/30/2017: No significant change observed.					
08/16/2016: No significant change observed.					
08/12/2015: No significant change observed.					
08/20/2014: No significant change observed.					
09/12/2013: No significant change observed.					
08/22/2012: Pocket erosion at the levee toe and slope. The erosion is covered with dense vegetation. There is no levee structure on site. The levee crest width and levee height were not measured or estimated in the field. [2017 Site ID:NA0017U16RM13.86]

Front view of the erosion.

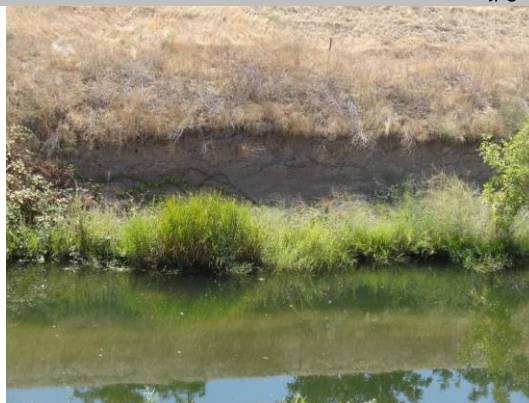
Photo 2 of 4 : SJR2017_NA0017U16RM13.86_2.jpg

Close view of the erosion.

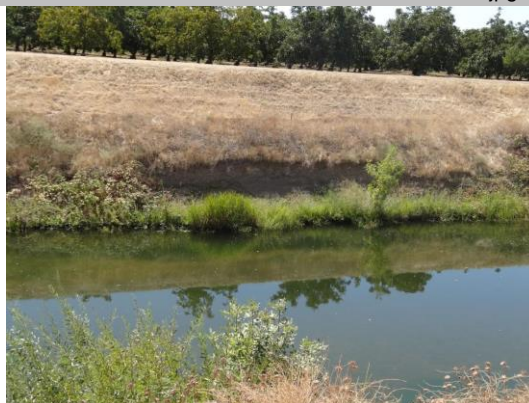
Photo 3 of 4 : SJR2017_NA0017U16RM13.86_3.jpg

Close view of the erosion.
