**Flood Control Project Maintenance
Levee Inspections**

Maintenance Issue Types Only, Levee Inspection Report By Mile - Fall 2017

San Joaquin County Flood Control and Water Conservation District

Waterway	Bank	Unit Miles	Inspection Start/End	Inspector
Unit No. 01 Littlejohn Creek	Left	2.59	10/17/2017 10/17/2017	Pavel Kazi

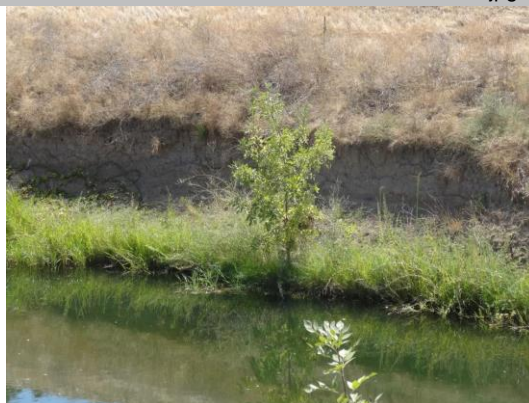
Photo 4 of 4 : SJR2017_NA0017U16RM13.86_4.jpg

Close view of the erosion. Note the dense vegetation at the site.

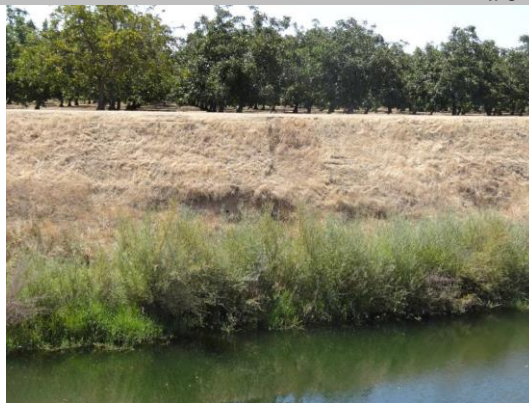
Photo 1 of 4 : SJR2017_NA0017U16RM13.85_1.jpg

LM Start	9.03	Rating **	U	Issue No.	27
LM End	9.03	Issue Type +	Ma	Location *	WS
Category	Supplemental			GPS Latitude/Longitude	
				Start	End
Item	DWR Erosion Survey			37.966661 °	37.966661 °
				-121.127864 °	-121.127864 °
DWR ID	NA0017U16RM13.85				
Comment Code					
Inspector Comment					
08/30/2017: No significant change observed.					
08/16/2016: No significant change observed.					
08/12/2015: No significant change observed.					
08/20/2014: No significant change observed.					
09/12/2013: The erosion might have been caused by river flow combined with runoff. Dense vegetation is presents at the site. There is no levee structure on site. The levee crest width and levee height were not measured or estimated in the field. [2017 Site ID:NA0017U16RM13.85]

View of the site from right river bank.

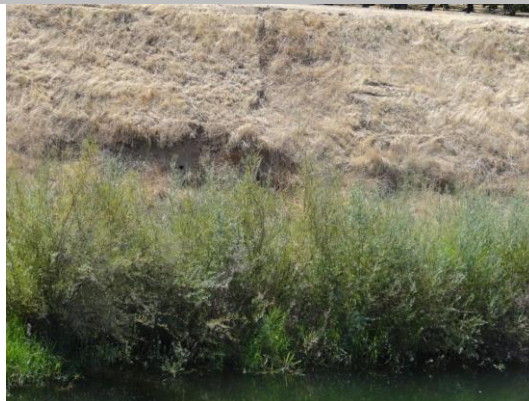
Photo 2 of 4 : SJR2017_NA0017U16RM13.85_2.jpg

Close view of the erosion.

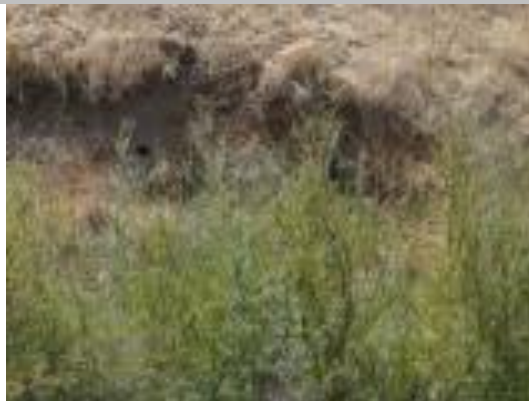
Photo 3 of 4 : SJR2017_NA0017U16RM13.85_3.jpg

Close view of the erosion.

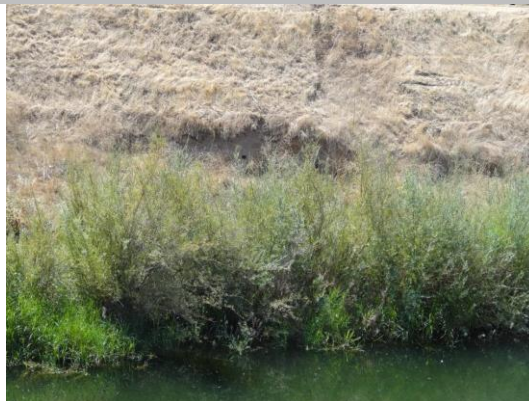
Photo 4 of 4 : SJR2017_NA0017U16RM13.85_4.jpg

Close view of the erosion.

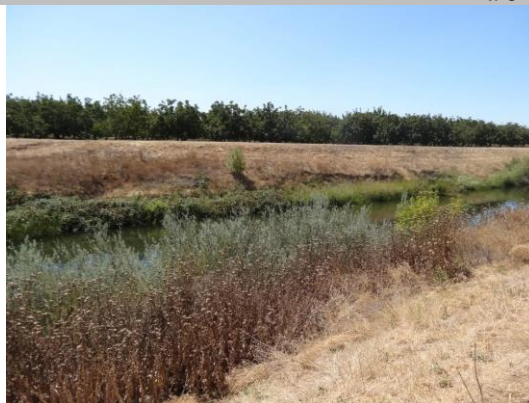
Photo 1 of 4 : SJR2017_NA0017U16RM13.72_1.jpg

LM Start	9.11	Rating **	M	Issue No.	18
LM End	9.13	Issue Type +	Ma	Location *	WS
Category	Supplemental			GPS Latitude/Longitude	
				Start	End
Item	DWR Erosion Survey			37.966922 °	37.966922 °
				-121.129533 °	-121.129533 °
DWR ID	NA0017U16RM13.72				
Comment Code					
Inspector Comment					
08/30/2017: No significant change observed. 08/16/2016: No significant change observed. 08/12/2015: No significant change observed. 08/20/2014: No significant change observed. 09/12/2013: No significant change observed. 08/22/2012: The erosion is covered with dense vegetation. There is no levee structure on site. The levee crest width and levee height were not measured or estimated in the field. [2017 Site ID:NA0017U16RM13.72]

Upstream view of the erosion.

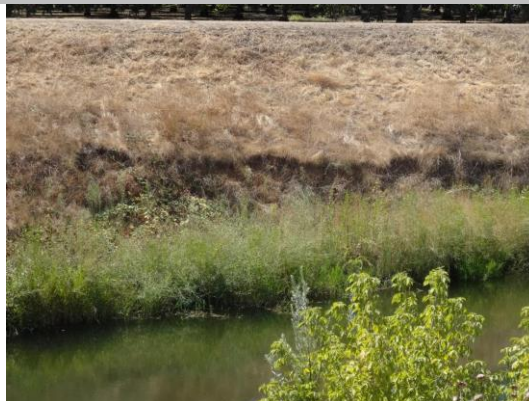
Photo 2 of 4 : SJR2017_NA0017U16RM13.72_2.jpg

Close view of the erosion.

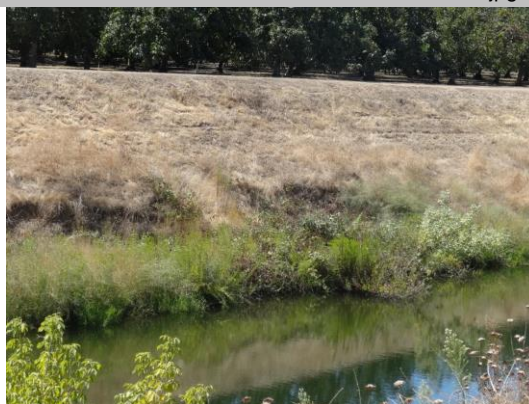
Photo 3 of 4 : SJR2017_NA0017U16RM13.72_3.jpg

Close view of the erosion.

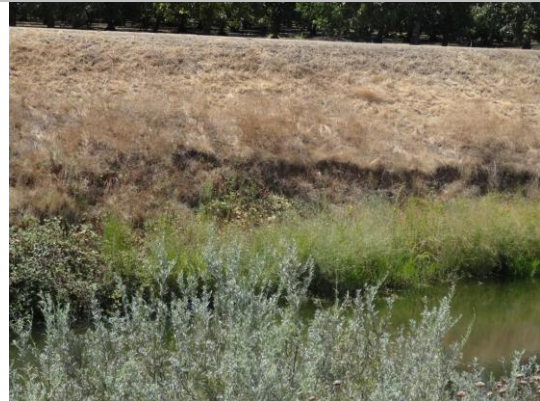
Photo 4 of 4 : SJR2017_NA0017U16RM13.72_4.jpg

Front view of the erosion.

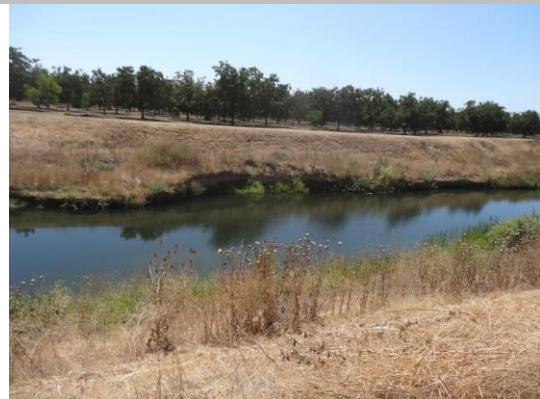
Photo 1 of 3 : SJR2017_NA0017U16RM13.53_1.jpg

LM Start	9.31	Rating **	M	Issue No.	14
LM End	9.33	Issue Type +	Ma	Location *	WS
Category	Supplemental			GPS Latitude/Longitude	
				Start	End
Item	DWR Erosion Survey			37.966772 °	37.966772 °
				-121.133071 °	-121.133071 °
DWR ID	NA0017U16RM13.53				
Comment Code					
Inspector Comment					
08/30/2017: No significant change observed.					
08/16/2016: No significant change observed.					
08/12/2015: No significant change observed.					
08/20/2014: No significant change observed.					
09/12/2013: No significant change observed.					
08/22/2012: The erosion is on berm. The berm width is estimated.					
There is no levee structure on site. The levee crest width and levee height were not measured or estimated in the field. [2017 Site ID:NA0017U16RM13.53]

Upstream view of the erosion.

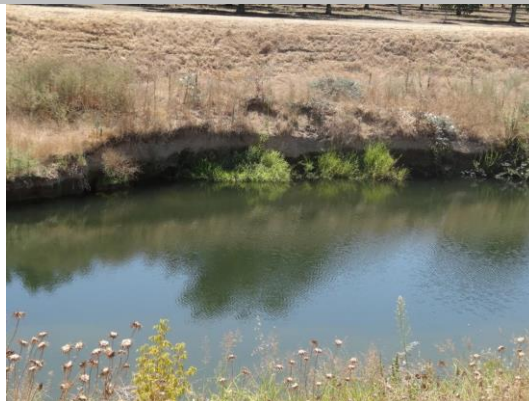
Photo 2 of 3 : SJR2017_NA0017U16RM13.53_2.jpg

Close view of the erosion.

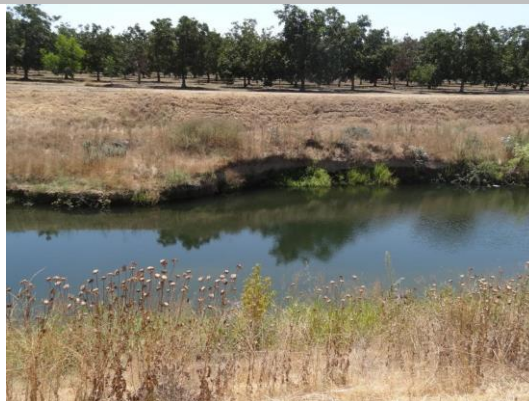
Photo 3 of 3 : SJR2017_NA0017U16RM13.53_3.jpg

Close view of the erosion.

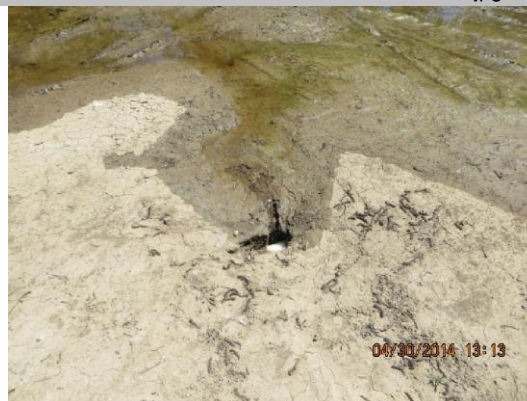
Photo 1 of 3 : UCIP_FA_2017_36144_65406.jpg

LM Start	9.48	Rating **	M	Issue No.	829
LM End	9.48	Issue Type +	Ma	Location *	
Category	Supplemental			GPS Latitude/Longitude	
				Start	End
Item	DWR UCIP LMA Responsibility			37.965880 °	37.965880 °
				-121.135897 °	-121.135897 °
DWR ID					
Comment Code					
Inspector Comment					
FS_ID:36144					
DS_ID:23344					
EP_NO: N/A					
Repair Type: Non-Urgent					
Crossing Status: Found					
UCIP Comments: Inlet appears to be burried with soil on LS. Pipe heavily corroded at outlet on WS toe. Good candidate for video inspection.					
FIELD_STRUCT_DESC: 18-inch corrugated metal drainage pipe, 3.5 feet below the roadway. Grouted spillway and inlet. [Additional Reference(s): DWR Levee Log, 1992. USACE San Joaquin O&M Manual 611.1, Volume F, (HLM 9.77)].					
FS Date: 4/30/2014

Inlet on LS shoulder burried in soil.

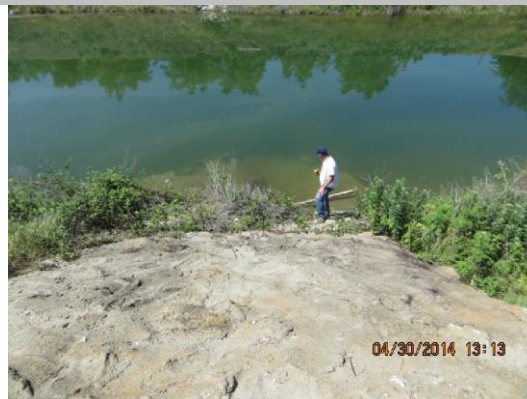
Photo 2 of 3 : UCIP_FA_2017_36144_65405.jpg

Grout over pipe on WS slope with pipe visible in water at WS toe.

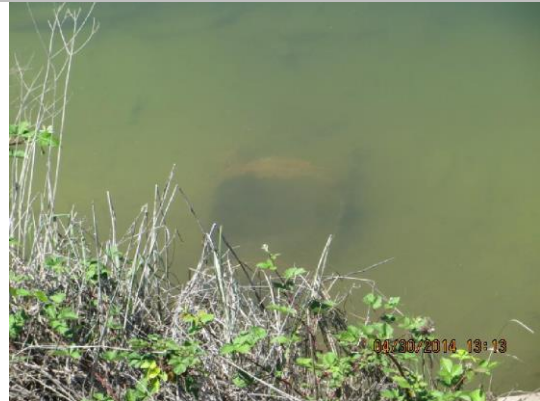
Photo 3 of 3 : UCIP_FA_2017_36144_65404.jpg

Pipe completely rusted through at outlet on WS toe.

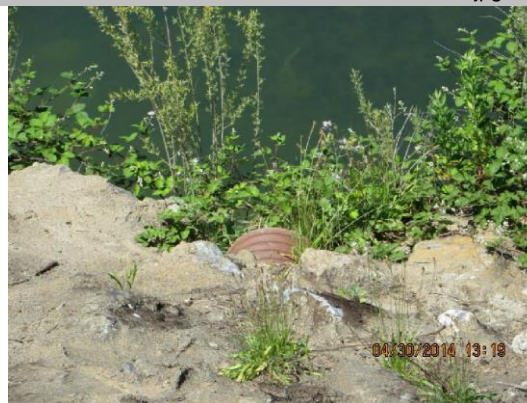
Photo 2 of 3 : UCIP_FA_2017_36145_65408.jpg

LM Start	9.78	Rating **	M	Issue No.	830 (cont)	
LM End	9.78	Issue Type +	Ma	Location *		
Category	Supplemental			GPS Latitude/Longitude		
				Start	End	
Item	DWR UCIP LMA Responsibility			37.964912 °	37.964912 °	
				-121.140827 °	-121.140827 °	
DWR ID						
Comment Code						
Inspector Comment						
FS_ID:36145						
DS_ID:23345						
EP_NO: N/A						
Repair Type: Non-Urgent						
Crossing Status: Found						
UCIP Comments: Inlet on LS buried in soil.						
FIELD_STRUCT_DESC: 18-inch corrugated metal drainage pipe						
through the levee, 3.5 feet below the crown. Grouted spillway and inlet.						
[Additional Reference(s): DWR Levee Log, 1992. USACE San Joaquin						
O&M Manual 611.1, Volume F, (HLM 10.07)].						
FS Date: 4/30/2014

Pipe at outlet on WS toe.

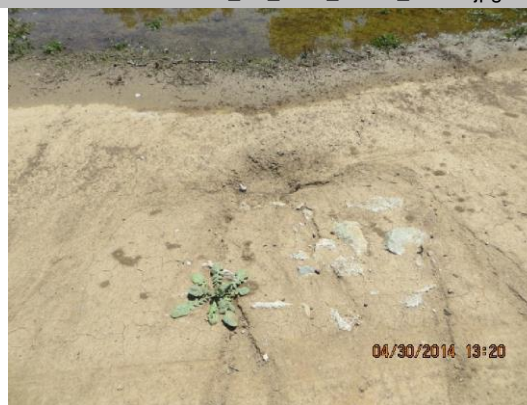
Photo 3 of 3 : UCIP_FA_2017_36145_65407.jpg

Inlet appears to be buried in soil on LS shoulder.

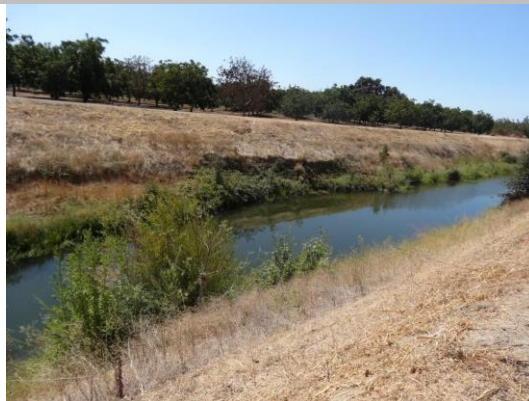
Photo 1 of 4 : SJR2017_NA0017U16RM12.95_1.jpg

LM Start	9.86	Rating **	M	Issue No.	10
LM End	9.88	Issue Type +	Ma	Location *	WS
Category	Supplemental			GPS Latitude/Longitude	
				Start	End
Item	DWR Erosion Survey			37.964735 °	37.964735 °
				-121.142503 °	-121.142503 °
DWR ID	NA0017U16RM12.95				
Comment Code					
Inspector Comment					
08/30/2017: No significant change observed. 08/16/2016: No significant change observed. 08/12/2015: No significant change observed. 08/20/2014: No significant change observed. 09/12/2013: No significant change observed. 08/22/2012: Dense vegetation on site. There is no levee structure on site. The levee crest width and levee height were not measured or estimated in the field. [2017 Site ID:NA0017U16RM12.95]

Upstream view of the site from right river bank.

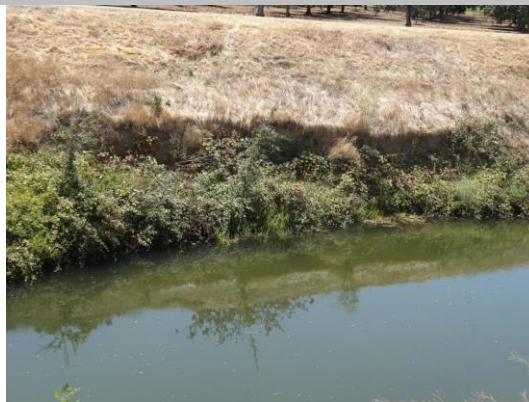
Photo 2 of 4 : SJR2017_NA0017U16RM12.95_2.jpg

Close view of the erosion.

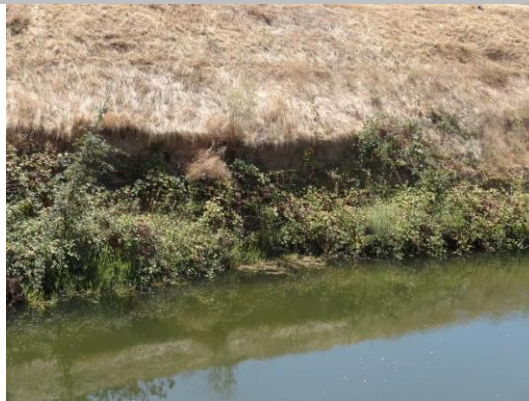
Photo 3 of 4 : SJR2017_NA0017U16RM12.95_3.jpg

Close view of the erosion.

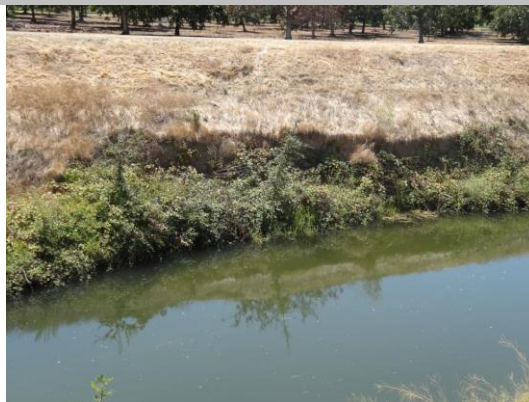
Photo 4 of 4 : SJR2017_NA0017U16RM12.95_4.jpg

Close view of the erosion.

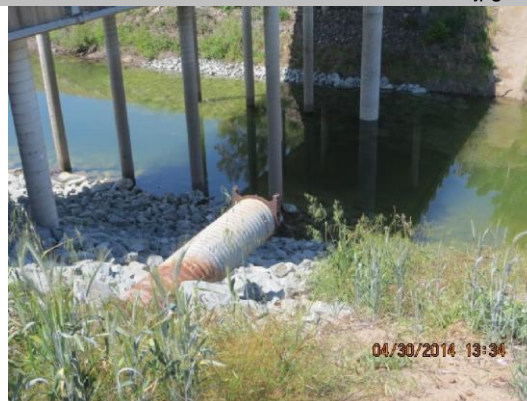
Photo 1 of 3 : UCIP_FA_2017_36163_65442.jpg

LM Start	10.20	Rating **	M	Issue No.	832
LM End	10.20	Issue Type +	Ma	Location *	
Category	Supplemental			GPS Latitude/Longitude	
				Start	End
Item	DWR UCIP LMA Responsibility			37.964670 °	37.964670 °
				-121.148455 °	-121.148455 °
DWR ID					
Comment Code					
Inspector Comment					
FS_ID:36163					
DS_ID:23347					
EP_NO: N/A					
Repair Type: Non-Urgent					
Crossing Status: Found					
UCIP Comments: Heavy sediment buildup at inlet on LS toe.					
FIELD_STRUCT_DESC: 18-inch corrugated metal drainage pipe through the levee, 5.5 feet below the crown. Concrete U-shaped headwall on the landside (LS). Flap gate on the waterside (WS) end.					
[Additional Reference(s): DWR Levee Log, 1992. USACE San Joaquin O&M Manual 611.1, Volume F, (HLM 10.50)].					
FS Date: 4/30/2014

Pipe and flapgate visible on WS slope.

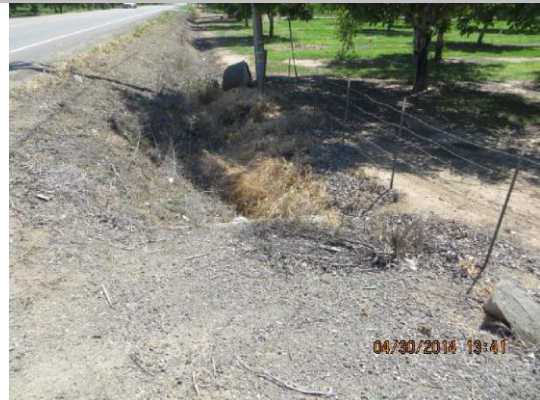
Photo 1 of 3 : UCIP_FA_2017_36164_65445.jpg

Pipe and concrete headwall on LS toe.

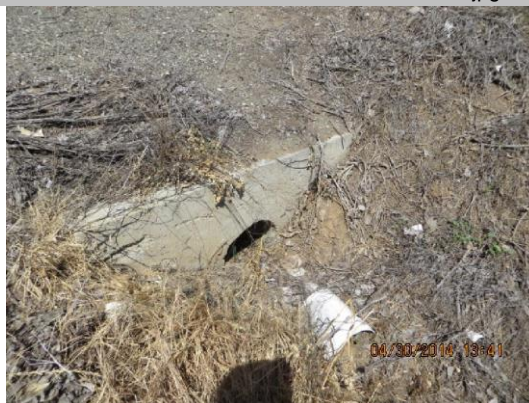
Photo 2 of 3 : UCIP_FA_2017_36164_65444.jpg

Pipe and concrete headwall on LS toe. Sediment buildup on LS toe.

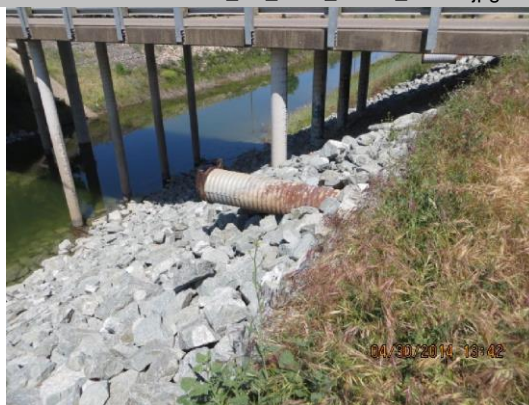
Photo 3 of 3 : UCIP_FA_2017_36164_65443.jpg

Pipe and flapgate visible on WS slope.

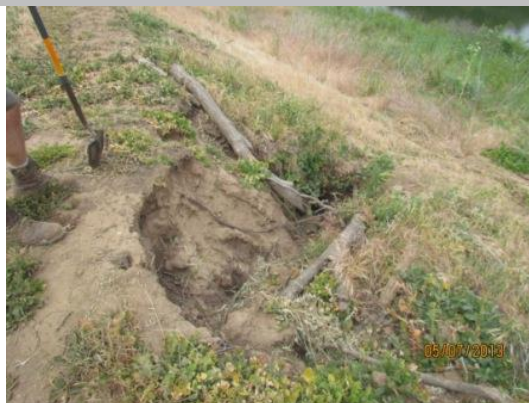
Photo 2 of 2 : FA_2017_NA0017_160_139_20171016_00120.jpg

LM Start	10.79	Rating **	A/W	Issue No.	139 (cont)	
LM End	10.79	Issue Type +	Ma	Location *	WS	
Category	Earthen Levee			GPS Latitude/Longitude		
				Start		End
Item	Erosion / Bank Caving			37.962182 °		37.962182 °
				-121.158684 °		-121.158684 °
DWR ID	DWR_NA0017_16_s_2013_139					
Comment Code						
E2 : Schedule repair of erosion site prior to the next inspection.						
Inspector Comment

Erosion was found on the waterside of the levee looking downstream.

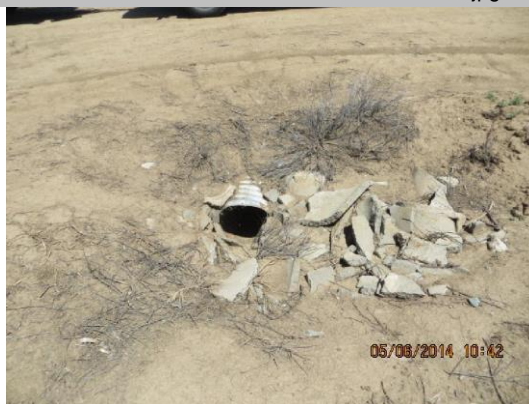
Photo 1 of 2 : UCIP_FA_2017_36186_65505.jpg

Pipe at inlet on LS toe.

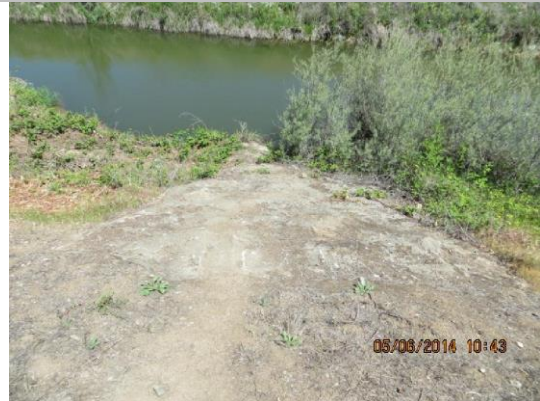
Photo 2 of 2 : UCIP_FA_2017_36186_65504.jpg

Grout over pipe on WS slope.

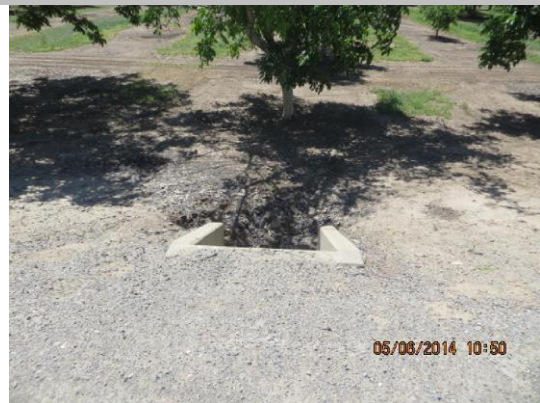
Photo 1 of 3 : UCIP_FA_2017_36187_65508.jpg

Pipe and headwall visible on LS toe.

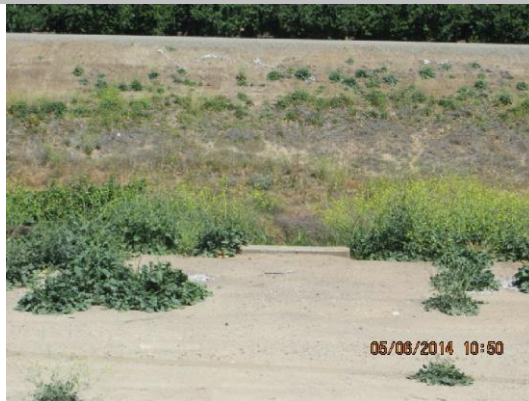
Photo 2 of 3 : UCIP_FA_2017_36187_65507.jpg

Pipe, flapgate, and headwall visible on WS shoulder.

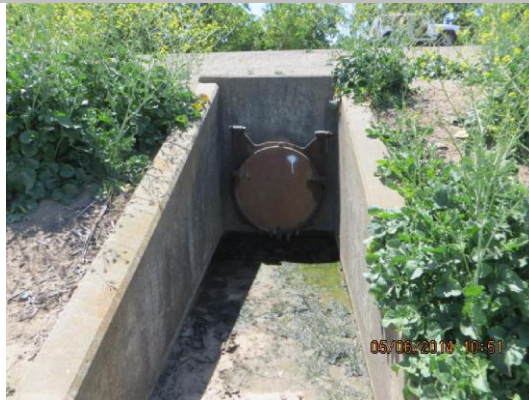
Photo 3 of 3 : UCIP_FA_2017_36187_65506.jpg

Pipe, flapgate, and headwall visible on WS shoulder.

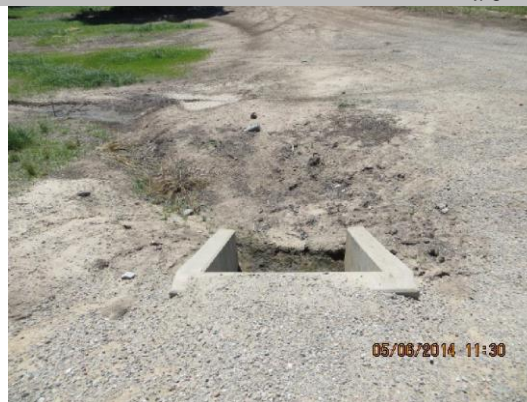
Photo 1 of 3 : UCIP_FA_2017_36208_65571.jpg

Concrete headwall on LS toe.

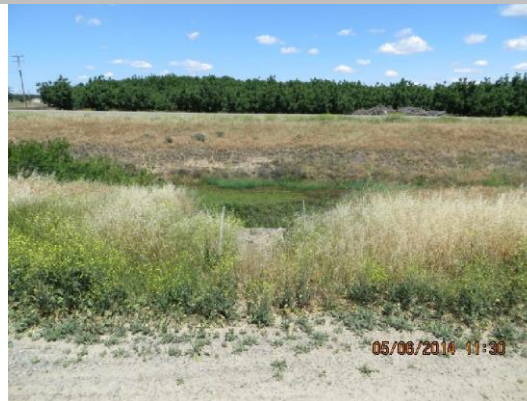
Photo 2 of 3 : UCIP_FA_2017_36208_65570.jpg

Pipe and concrete headwall on WS slope.

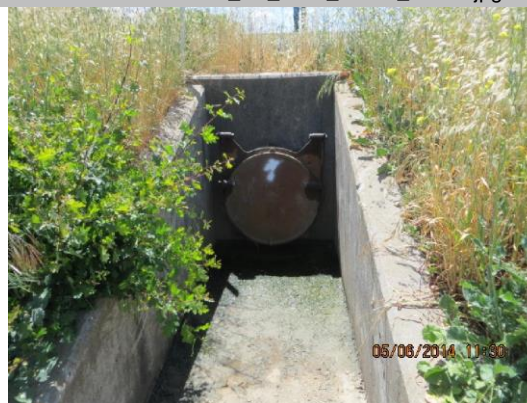
Photo 3 of 3 : UCIP_FA_2017_36208_65569.jpg

Pipe, headwall, and flapgate on WS slope.

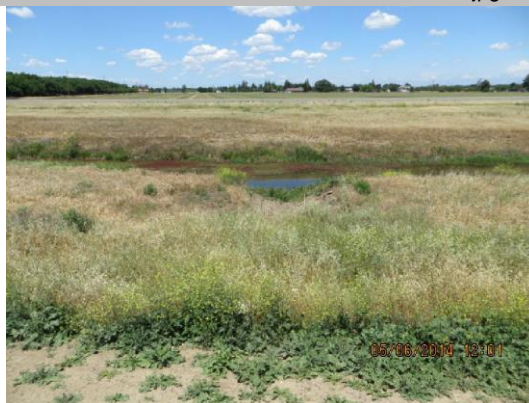
Photo 1 of 3 : UCIP_FA_2017_36225_65589.jpg

Grouted spillway on WS berm.

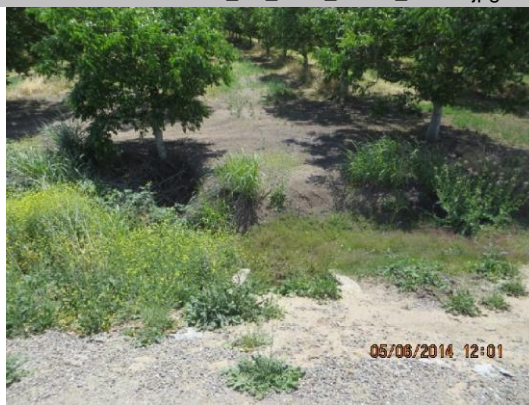
Photo 2 of 3 : UCIP_FA_2017_36225_65588.jpg

Concrete headwall on LS toe.

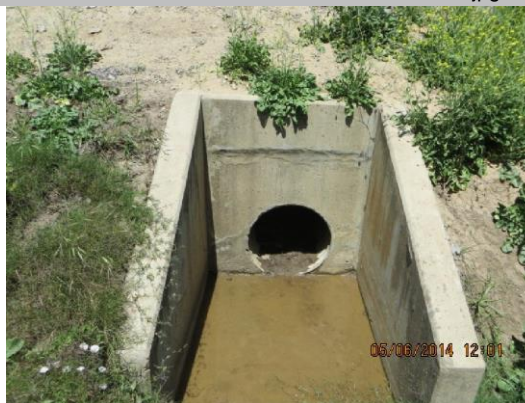
Photo 3 of 3 : UCIP_FA_2017_36225_65587.jpg

Concrete headwall on LS toe.

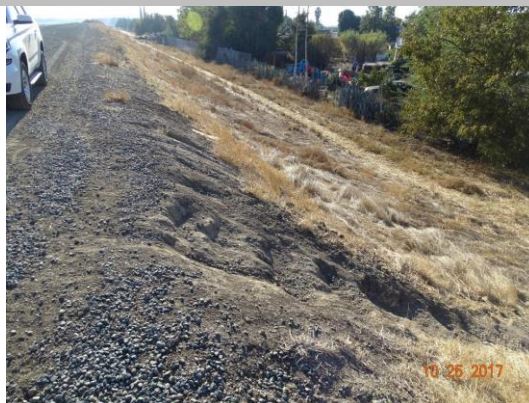
Photo 1 of 1 : FA_2017_NA0017_160_256_20171027_00436.jpg

LM Start	14.19	Rating **	M	Issue No.	256
LM End	14.19	Issue Type +	Ma	Location *	LS
Category	Earthen Levee			GPS Latitude/Longitude	
				Start	End
Item	Slope Stability			37.966596 °	37.966596 °
				-121.216410 °	-121.216410 °
DWR ID	DWR_NA0017_16_f_2017_256				
Comment Code					
S2 : Repair the levee slope damaged by foot traffic and prevent access where possible.					
Inspector Comment

View of a stairway dug into the landside slope of the levee looking upstream. Fall 2017

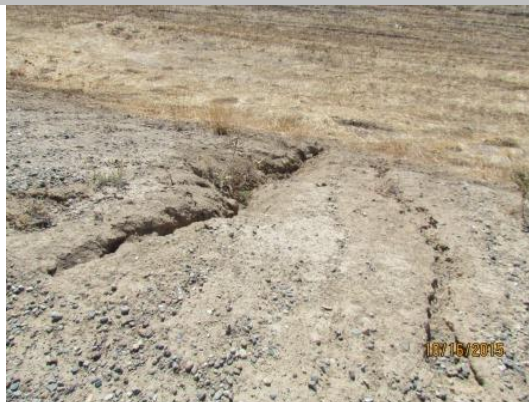
Photo 1 of 1 : FA_2017_NA0017_160_249_20171016_00156.jpg

LM Start	14.25	Rating **	M	Issue No.	249
LM End	14.25	Issue Type +	Ma	Location *	LS
Category	Earthen Levee			GPS Latitude/Longitude	
				Start	End
Item	Erosion / Bank Caving			37.967046 °	37.967046 °
				-121.217319 °	-121.217319 °
DWR ID	DWR_NA0017_16_f_2015_249				
Comment Code					
E2 : Schedule repair of erosion site prior to the next inspection.					
Inspector Comment					
Runoff

View of the erosion caused by surface runoff on the landside of the

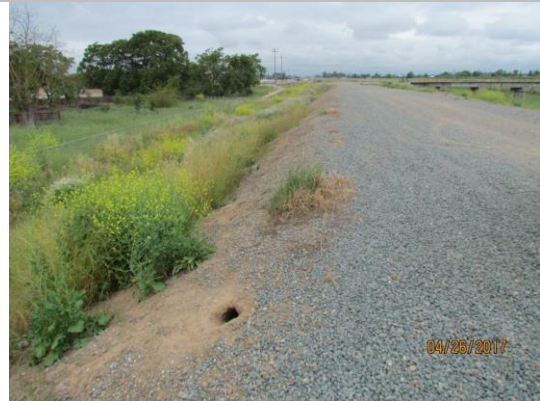
Photo 1 of 1 : FA_2017_NA0017_160_259_20171016_00161.jpg

LM Start	14.59	Rating **	M	Issue No.	259
LM End	14.59	Issue Type +	Ma	Location *	LS
Category	Earthen Levee			GPS Latitude/Longitude	
				Start	End
Item	Animal Control			37.969732 °	37.969732 °
				-121.222552 °	-121.222552 °
DWR ID	DWR_NA0017_16_f_2014_259				
Comment Code					
A3 : No rodents visible, but rodent burrows visible; need to backfill and compact or grout burrows.					
Inspector Comment

View of a rodent hole on the landside of the levee. Spring 2017

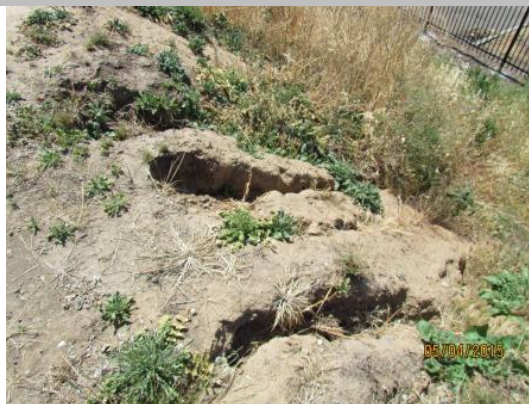
Photo 1 of 2 : FA_2017_NA0017_160_150_20171016_00122.jpg

LM Start	16.43	Rating **	M	Issue No.	150
LM End	16.43	Issue Type +	Ma	Location *	LS
Category	Earthen Levee			GPS Latitude/Longitude	
				Start	End
Item	Erosion / Bank Caving			37.982318 °	37.982318 °
				-121.252095 °	-121.252095 °
DWR ID	DWR_NA0017_16_s_2013_150				
Comment Code					
E2 : Schedule repair of erosion site prior to the next inspection.					
Inspector Comment					
Runoff

Updated picture of the erosion on the landside shoulder of the levee looking upstream during spring 2015 inspection.

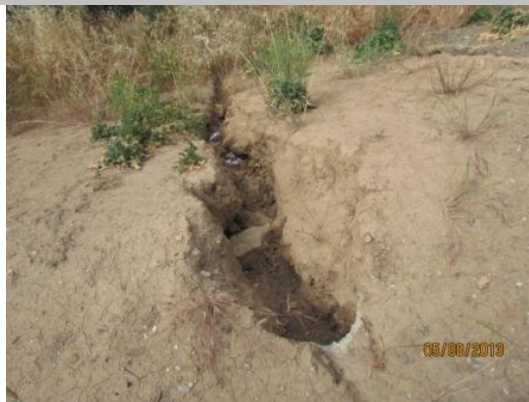
Photo 2 of 2 : FA_2017_NA0017_160_150_20171016_00123.jpg

Erosion was found on the landside of the levee looking downstream.

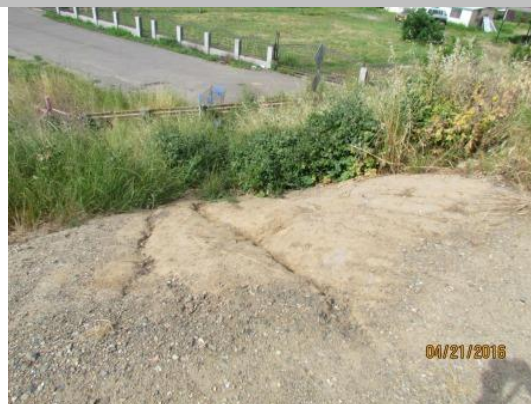
Photo 1 of 1 : FA_2017_NA0017_160_293_20171016_00190.jpg

LM Start	17.14	Rating **	M	Issue No.	293	
LM End	17.14	Issue Type +	Ma	Location *	LS	
Category	Earthen Levee			GPS Latitude/Longitude		
				Start		End
Item	Erosion / Bank Caving			37.987210 °		37.987210 °
				-121.263501 °		-121.263501 °
DWR ID	DWR_NA0017_16_s_2016_293					
Comment Code						
E2 : Schedule repair of erosion site prior to the next inspection.						
Inspector Comment						
Runoff

View of an erosion on the landside slope of the levee.

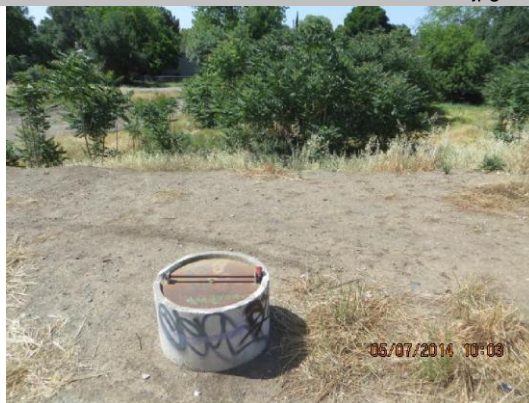
Photo 1 of 3 : UCIP_FA_2017_37124_67563.jpg

24-inch concrete riser on LS shoulder.

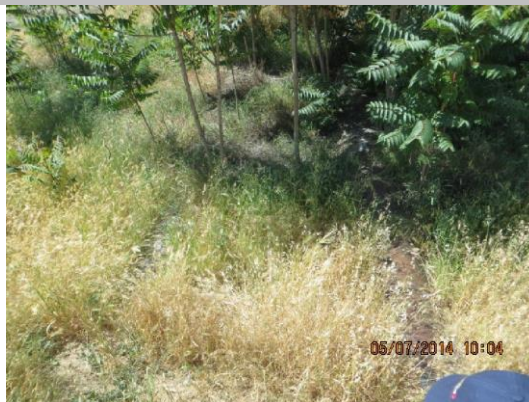
Photo 2 of 3 : UCIP_FA_2017_37124_67562.jpg

Pipe visible on left at LS toe.

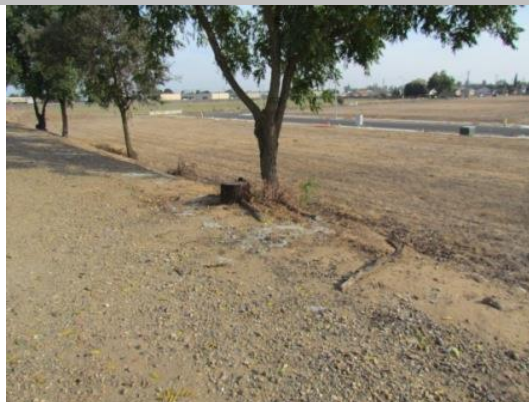
Photo 1 of 1 : FA_2017_NA0017_160_65_20171016_00061.jpg

LM Start	19.04	Rating **	N	Issue No.	65
LM End	19.04	Issue Type +	Ma	Location *	LS
Category	Earthen Levee			GPS Latitude/Longitude	
				Start	End
Item	Trim / Thin Trees			37.991617 °	37.991617 °
				-121.295628 °	-121.295628 °
DWR ID	DWR_NA0017_16_s _ 2012_65				
Comment Code					
T5 : Tree stumps.					
Inspector Comment

A tree stump was found on the landside of the levee looking upstream.

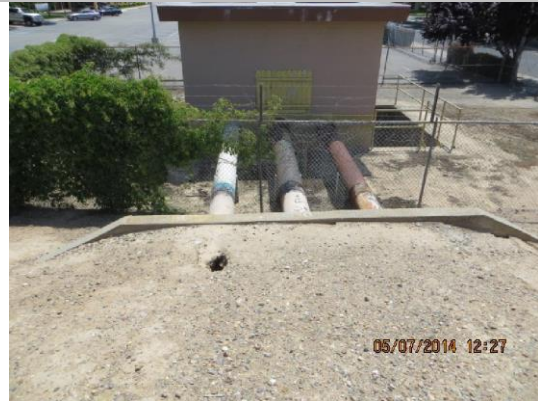
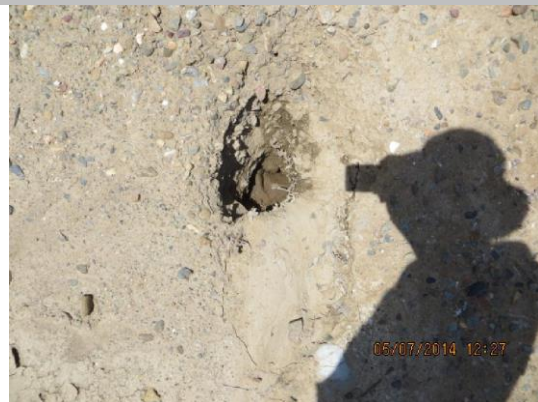
FS_ID:51631
DS_ID:23374
EP_NO: 3175
Repair Type: Urgent
Crossing Status: Found
UCIP Comments: 10/31/2016 Sink hole along pipe alignment (on LS) has progressed, the hole is now about 4-feet long by 2.5-feet wide by 3-feet deep. Several signs of pipe failure are present at this location visible on both WS and LS. The DWR Levee inspector, the LMA, and the owner - the City of Stockton have been notified of the damage to both the WS and LS. Owner will need to contact the CVFPB to address pipe and levee repairs. (O. Magana - DWR UCIP)05/07/2014 Wet hole over pipe on LS slope indicating pipe failure. (W. Wylie - DWR UCIP)
FIELD_STRUCT_DESC: 1 of 3: 16-inch steel drainage pipe through the levee, 3.5 feet below the crown. Flap gate is located on the waterside (WS) end. Siphon breaker is inside a 42-inch concrete riser that is located on the WS shoulder. Concrete headwall is located at the landside (LS) toe. Concrete block pump house with chain link fence around it is located on the LS. (Permit No. 3175, 1966 - City of Stockton; additional reference for this pump station includes Permit No. 3175-A, 2003 - OMI/Thames Water Stockton, Inc. permit was issued for an emergency repair of a damaged section of 18-inch pipe) [Additional Reference(s): DWR Levee Log, 1977. USACE San Joaquin River O&M Manual Unit No. 611.1, (HLM 19.68)].

Hole over pipe on LS slope.

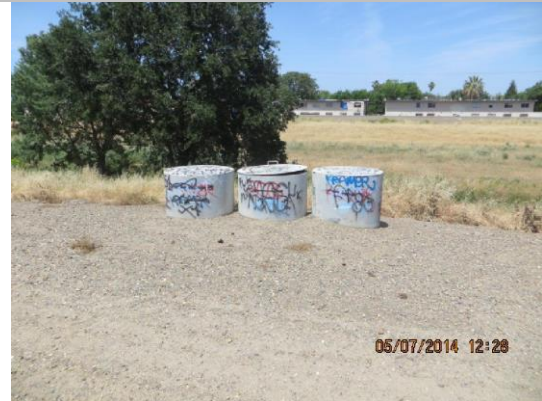
Photo 3 of 3 : UCIP_FA_2017_51631_67700.jpg

vent in concrete standpipe on WS shoulder.

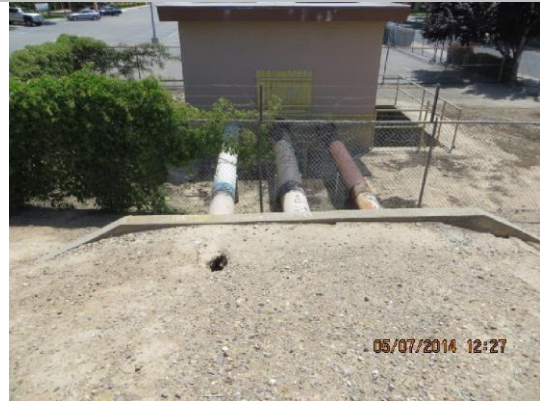
Photo 1 of 3 : UCIP_FA_2017_50770_67706.jpg

UCIP Comments: 10/31/2016 Hole is visible on WS toe. Several signs of multiple pipe failures at this location are visible on both WS and LS.

Pipe at center of picture.

Owner will need to contact the CVFPB to address pipe and levee repairs. Flap gate is still missing from WS toe. (O. Magana - DWR UCIP)05/07/2014 Flapgate missing from WS toe. (W. Wylie - DWR UCIP)

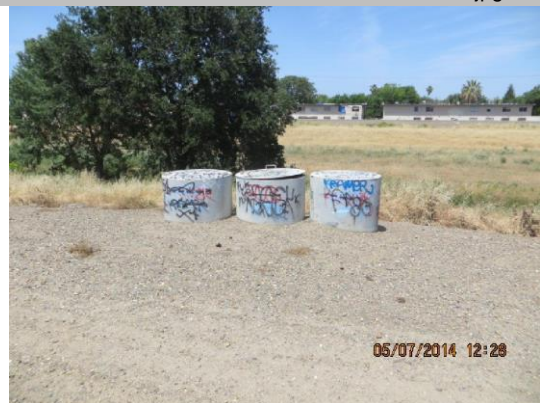
Photo 2 of 3 : UCIP_FA_2017_50770_67705.jpg

Center concrete riser on WS shoulder.

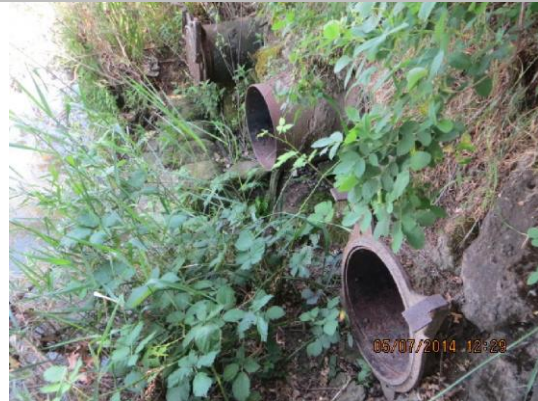
Photo 3 of 3 : UCIP_FA_2017_50770_67704.jpg

Flapgate missing from pipe on WS toe.

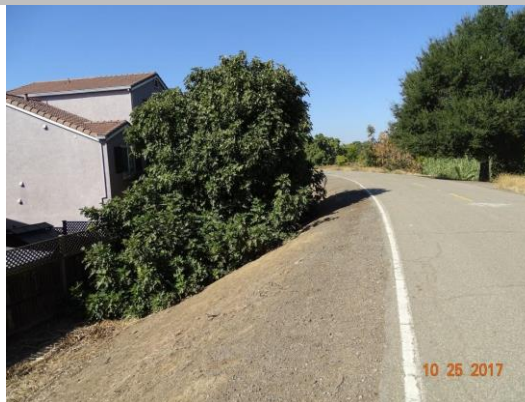
Photo 1 of 1 : FA_2017_NA0017_160_25_20171027_00438.jpg

LM Start	20.81	Rating **	M	Issue No.	25
LM End	20.81	Issue Type +	Ma	Location *	WS
Category	Earthen Levee			GPS Latitude/Longitude	
				Start	End
Item	Trim / Thin Trees			37.979925 °	37.979925 °
				-121.320179 °	-121.320179 °
DWR ID	DWR_NA0017_16_f_2017_25				
Comment Code					
T1 : Trim trees to at least five feet above ground level.					
Inspector Comment

View a tree that needs trimming on the landside slope of the levee. Fall 2017

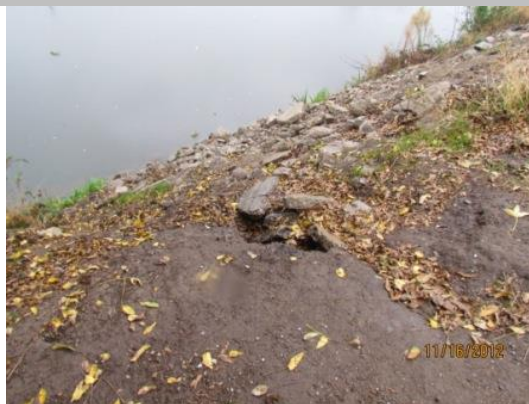
Photo 1 of 1 : FA_2017_NA0017_160_68_20171016_00066.jpg

LM Start	21.68	Rating **	M	Issue No.	68
LM End	21.68	Issue Type +	Ma	Location *	WS
Category	Earthen Levee			GPS Latitude/Longitude	
				Start	End
Item	Erosion / Bank Caving			37.979674 °	37.979674 °
				-121.335228 °	-121.335228 °
DWR ID	DWR_NA0017_16_f_2012_68				
Comment Code					
E2 : Schedule repair of erosion site prior to the next inspection.					
Inspector Comment

Erosion was found on the waterside slope of the levee looking upstream.

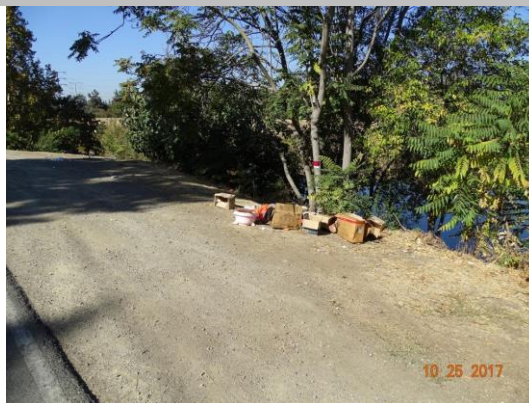
Photo 1 of 1 : FA_2017_NA0017_160_260_20171027_00439.jpg

LM Start	21.88	Rating **	M	Issue No.	260
LM End	21.88	Issue Type +	Ma	Location *	WS
Category	Earthen Levee			GPS Latitude/Longitude	
				Start	End
Item	Encroachments			37.979478 °	37.979478 °
				-121.338838 °	-121.338838 °
DWR ID	DWR_NA0017_16_f_2017_260				
Comment Code					
DE : Debris					
Inspector Comment

View of debris on the waterside shoulder of the levee. Fall 2017

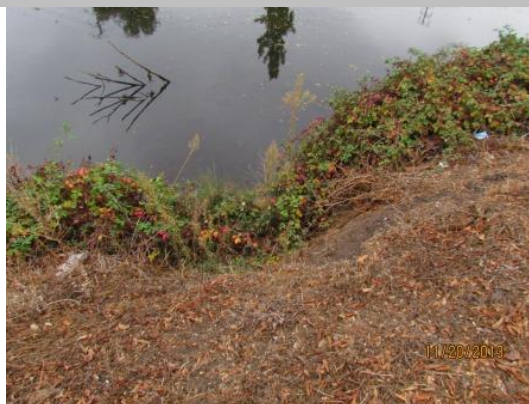
Photo 1 of 1 : FA_2017_NA0017_160_62_20171016_00060.jpg

LM Start	21.94	Rating **	M	Issue No.	62
LM End	21.94	Issue Type +	Ma	Location *	WS
Category	Earthen Levee			GPS Latitude/Longitude	
				Start	End
Item	Erosion / Bank Caving			37.979251 °	37.979251 °
				-121.340012 °	-121.340012 °
DWR ID	DWR_NA0017_16_f_2013_62				
Comment Code					
E2 : Schedule repair of erosion site prior to the next inspection.					
Inspector Comment

Erosion was found on the waterside slope of the levee looking upstream.

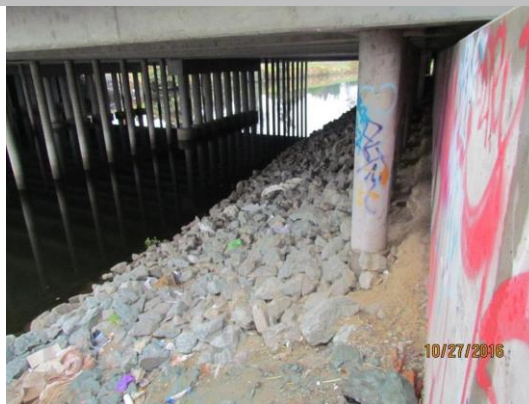
Photo 1 of 5 : FA_2017_NA0017_160_48_20171016_00044.jpg

LM Start	22.04	Rating **	A/W	Issue No.	48
LM End	22.04	Issue Type +	Ma	Location *	WS
Category	Earthen Levee			GPS Latitude/Longitude	
				Start	End
Item	Erosion / Bank Caving			37.978697 °	37.978697 °
				-121.341581 °	-121.341581 °
DWR ID	DWR_NA0017_16_s_2012_48				
Comment Code					
E2 : Schedule repair of erosion site prior to the next inspection.					
Inspector Comment					
Caltrans repaired the issue. (Permit # 18562) Another repair might be needed if it deteriorates.

View of the riprap on the waterside slope of the levee. Fall 2016

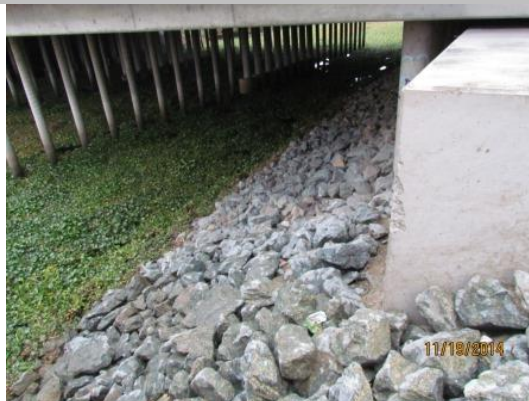
Photo 2 of 5 : FA_2017_NA0017_160_48_20171016_00045.jpg

Caltrans repaired the erosion under the southbound (I-5) bridge. The picture was taken from the crown looking upstream during fall 2014 inspection.

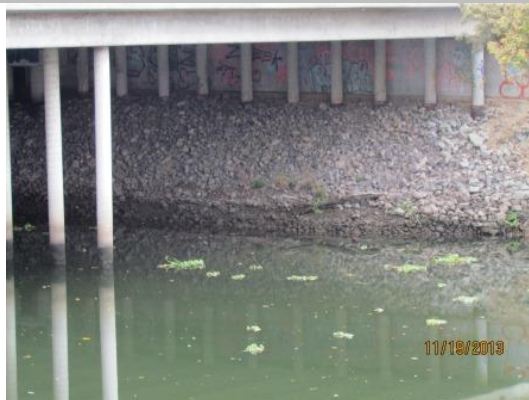
Photo 3 of 5 : FA_2017_NA0017_160_48_20171016_00046.jpg

Updated picture of erosion was found on the waterside toe of the levee looking from the opposite side of the levee. Fall 2013

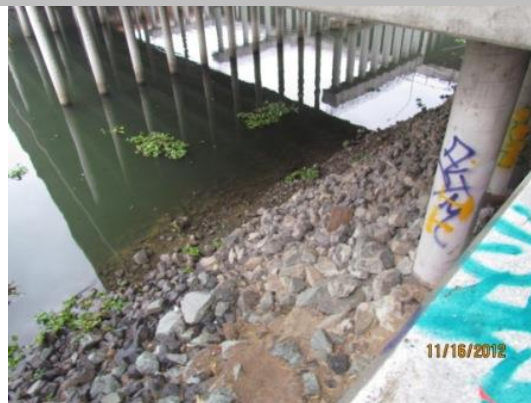
Photo 4 of 5 : FA_2017_NA0017_160_48_20171016_00047.jpg

Updated view of the erosion site repaired by Caltrans on the waterside slope of the levee looking upstream. Fall 2012

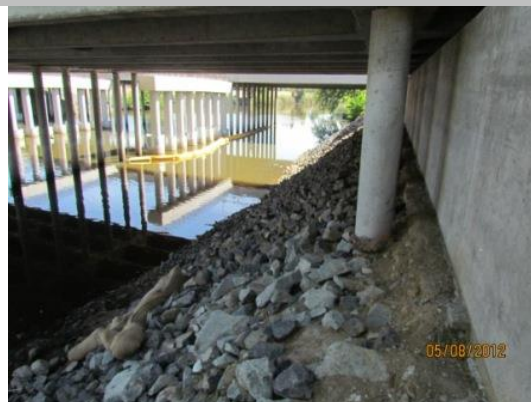
Photo 5 of 5 : FA_2017_NA0017_160_48_20171016_00048.jpg

View of the erosion site repaired by Caltrans under the I-5 freeway going southbound. This picture was taken from the toe of the levee looking upstream. Spring 2012

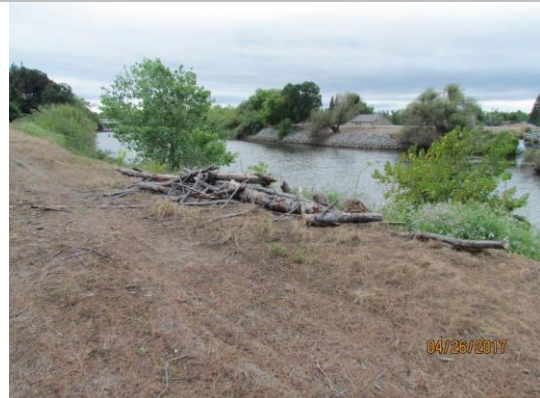
Photo 1 of 1 : FA_2017_NA0017_160_303_20171016_00193.jpg

LM Start	22.46	Rating **	M	Issue No.	303
LM End	22.46	Issue Type +	Ma	Location *	WS
Category	Earthen Levee			GPS Latitude/Longitude	
				Start	End
Item	Encroachments			37.974267 °	37.974267 °
				-121.346955 °	-121.346955 °
DWR ID	DWR_NA0017_16_s_2017_303				
Comment Code					
PR : Prunings					
Inspector Comment

View of prunings on the waterside of the levee.

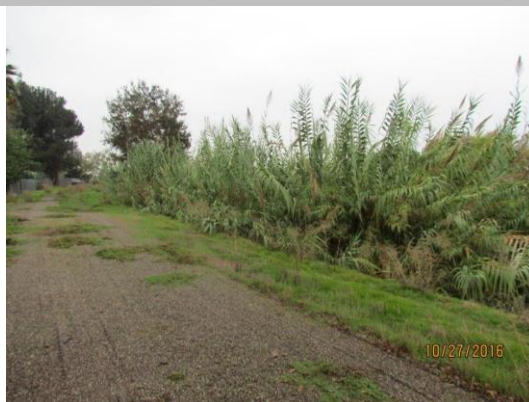
Photo 1 of 2 : FA_2017_NA0017_160_45_20171016_00039.jpg

LM Start	22.53	Rating **	U	Issue No.	45
LM End	22.53	Issue Type +	Ma	Location *	WS
Category	Earthen Levee			GPS Latitude/Longitude	
				Start	End
Item	Vegetation			37.973578 °	37.973578 °
				-121.347848 °	-121.347848 °
DWR ID	DWR_NA0017_16_f_2012_45				
Comment Code					
V2 : Remove the wild growth other than native grasses from the levee slopes.					
Inspector Comment					
Arundo on the waterside of the levee is completely blocking the visibility.

Updated picture of the arundo on the waterside slope of the levee. Fall 2016

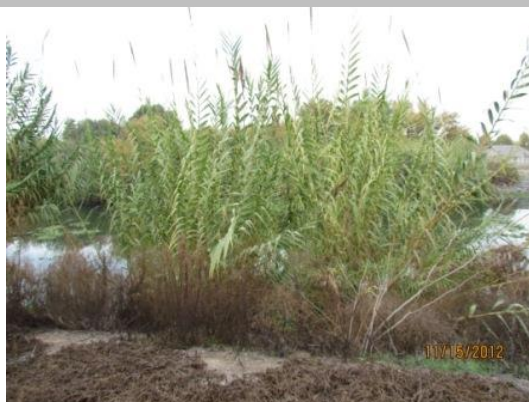
Photo 2 of 2 : FA_2017_NA0017_160_45_20171016_00040.jpg

Arundo was found on the waterside slope of the levee looking upstream.

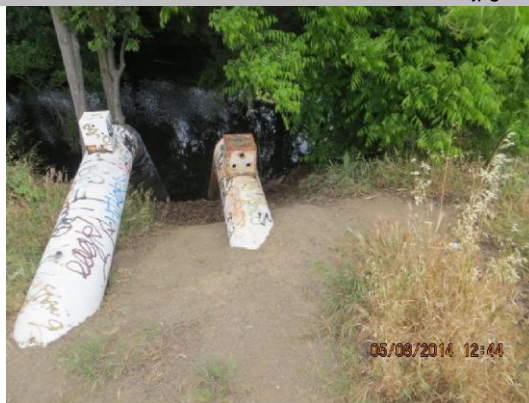
Photo 1 of 2 : UCIP_FA_2017_37423_67881.jpg

Pipe visible on WS slope with siphon breaker in box.

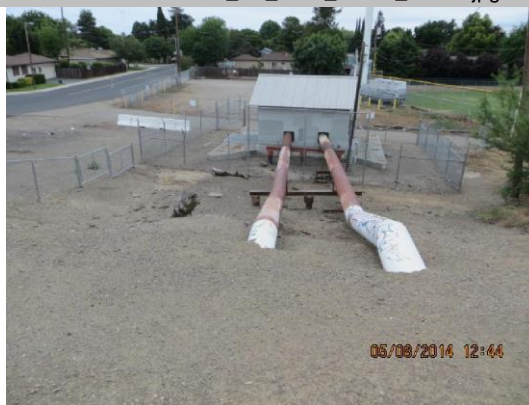
Photo 2 of 2 : UCIP_FA_2017_37423_67880.jpg

Pipe and pumphouse visible on LS toe.

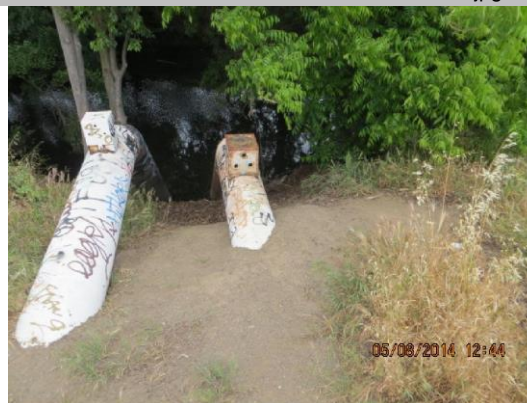
Photo 1 of 2 : UCIP_FA_2017_37424_67883.jpg

FS_ID:37424
DS_ID:23503
EP_NO: N/A
Repair Type: No Action Needed
Crossing Status: Found
UCIP Comments:
FIELD_STRUCT_DESC: 2 of 2: 20-inch steel drainage pipe through the levee, 3 feet below the crown. Siphon breaker on the waterside (WS) slope. Pump house near the landside (LS) toe. (Reclamation District No. 1618). [Additional Reference(s): DWR Levee Log, 1992. USACE San Joaquin O&M Manual 611.1, Volume F, (HLM 23.36)].
FS Date: 5/8/2014

Pipe and siphon breaker at left of photo.

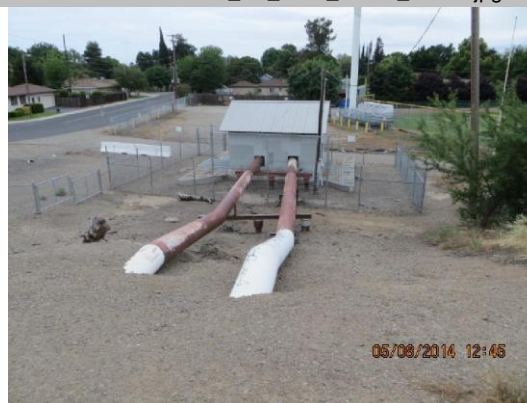
Photo 2 of 2 : UCIP_FA_2017_37424_67882.jpg

Pipe and pumphouse on LS toe.

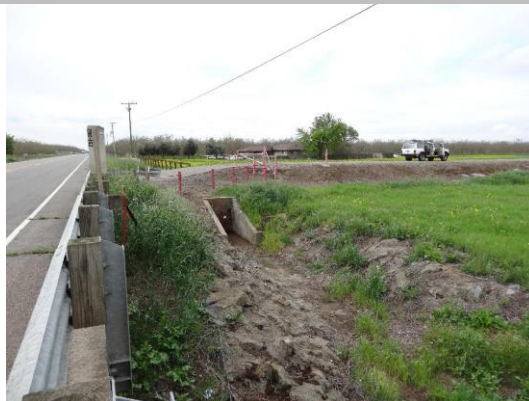
Photo 1 of 3 : UCIP_FA_2017_33112_59886.jpg

LM Start	0.00	Rating **	A/W	Issue No.	8
LM End	0.00	Issue Type +	Ma	Location *	
Category	Supplemental			GPS Latitude/Longitude	
				Start	End
Item	DWR UCIP LMA Responsibility			37.957538 °	37.957538 °
				-121.148502 °	-121.148502 °
DWR ID					
Comment Code					
Inspector Comment					
FS_ID:33112					
DS_ID:23952					
EP_NO: N/A					
Repair Type: No Action Needed					
Crossing Status: Found					
UCIP Comments: Looks well maintained crossing.					
FIELD_STRUCT_DESC: 30-inch CM pipe through the levee 6.0 feet below the crown. Concrete "U" headwalls on both ends. Flap gate on the waterward end. Grouted intake and outlet. O&M manual SJR 611.1 Vol. F- revised in 2010.					
FS Date: 4/4/2014

WS view: overview of pipe culvert and grouted riprap spillway.

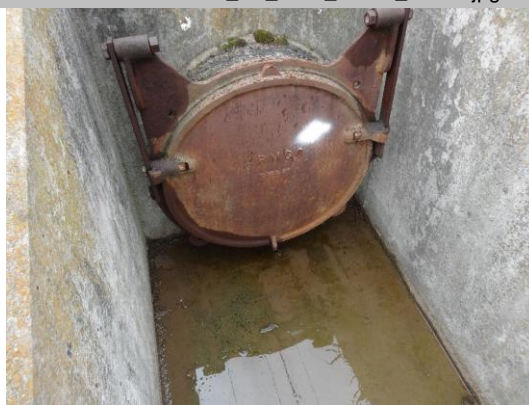
Photo 2 of 3 : UCIP_FA_2017_33112_59885.jpg

WS view: close view of CM pipe, flapgate, and concrete headwall.

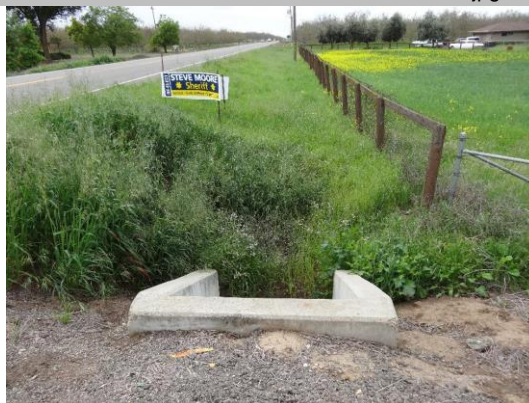
Photo 3 of 3 : UCIP_FA_2017_33112_59884.jpg

LS view: concrete headwall of pipe culvert.

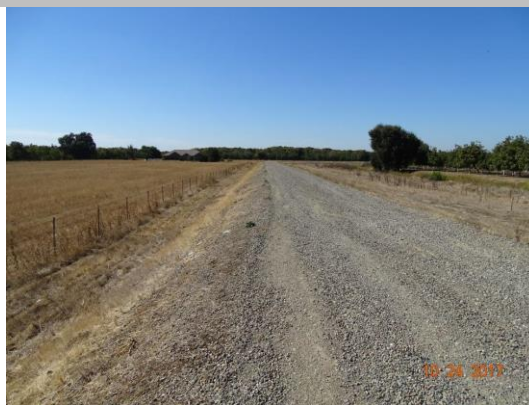
Photo 1 of 1 : FA_2017_NA0017_162_7_20171027_00014.jpg

LM Start	0.01	Rating **	A	Issue No.	7
LM End	0.01	Issue Type +	Ma	Location *	LS
Category	Earthen Levee			GPS Latitude/Longitude	
				Start	End
Item	Vegetation			37.957541 °	37.957541 °
				-121.148709 °	-121.148709 °
DWR ID	DWR_NA0017_18_f_2017_7				
Comment Code					
V1 : Control annual grass and weeds on the levee slopes and easements.					
Inspector Comment					
Acceptable vegetation.

View of the landside slope of the levee looking upstream. Fall 2017

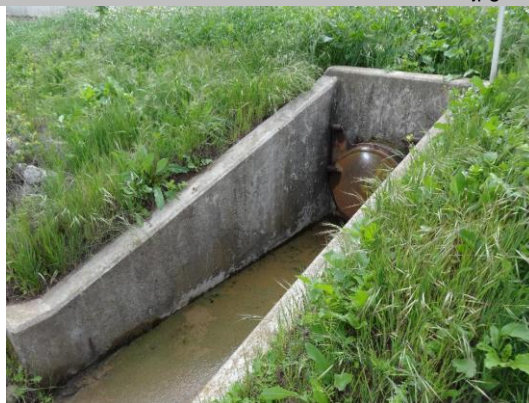
Photo 1 of 3 : UCIP_FA_2017_33113_59893.jpg

LM Start	0.28	Rating **	A/W	Issue No.	9
LM End	0.28	Issue Type +	Ma	Location *	
Category	Supplemental			GPS Latitude/Longitude	
				Start	End
Item	DWR UCIP LMA Responsibility			37.958658 °	37.958658 °
				-121.153090 °	-121.153090 °
DWR ID					
Comment Code					
Inspector Comment					
FS_ID:33113					
DS_ID:18541					
EP_NO: N/A					
Repair Type: No Action Needed					
Crossing Status: Found					
UCIP Comments: Long flood wall along the levee.					
FIELD_STRUCT_DESC: 30-inch corrugated metal drainage pipe through the levee, 6 feet below the crown. Concrete U-shaped headwall on both ends. Flap gate on the waterside (WS) end. Grouted inlet and outlet. [Additional Reference(s): DWR Levee Log, 1992, 36-inch pipe listed. USACE San Joaquin O&M Manual 611.1, Volume F, (HLM 0.28)].					
FS Date: 4/4/2014

WS view: CM pipe, flapgate, and concrete headwall on levee slope.

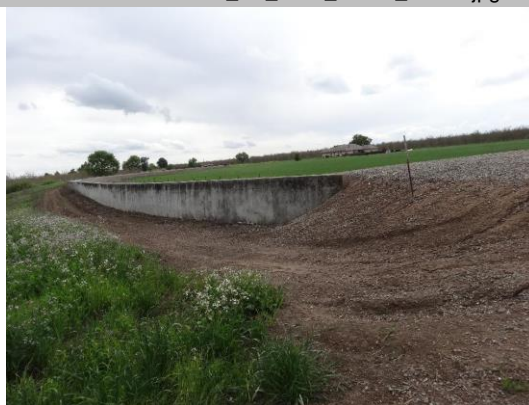
Photo 2 of 3 : UCIP_FA_2017_33113_59892.jpg

WS view: concrete flood wall along the levee on waterside.

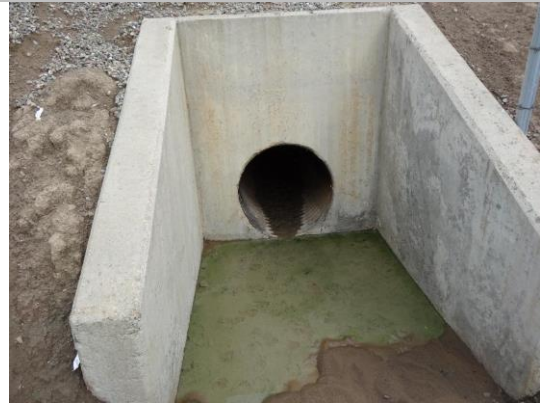
Photo 3 of 3 : UCIP_FA_2017_33113_59891.jpg

WS view: CM pipe, intake box, and concrete headwall on levee slope.
