**Flood Control Project Maintenance
Levee Inspections**

Maintenance Issue Types Only, Levee Inspection Report By Mile - Fall 2017

San Joaquin County Flood Control and Water Conservation District

Waterway	Bank	Unit Miles	Inspection Start/End	Inspector
Unit No. 01 Littlejohn Creek	Left	2.59	10/17/2017 10/17/2017	Pavel Kazi

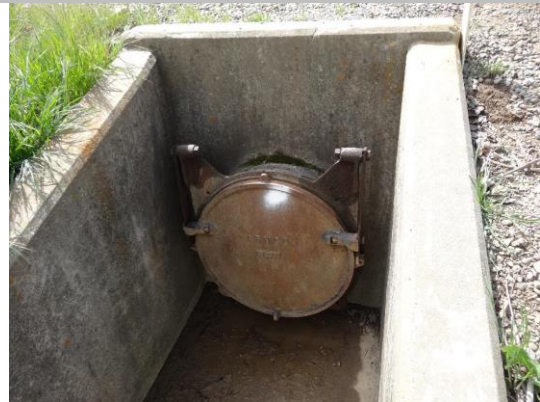
Photo 1 of 3 : UCIP_FA_2017_33114_59898.jpg

LM Start	0.53	Rating **	A/W	Issue No.	10
LM End	0.53	Issue Type +	Ma	Location *	
Category	Supplemental			GPS Latitude/Longitude	
				Start	End
Item	DWR UCIP LMA Responsibility			37.959117 °	37.959117 °
				-121.157567 °	-121.157567 °
DWR ID					
Comment Code					
Inspector Comment					
FS_ID:33114 DS_ID:18539 EP_NO: N/A Repair Type: No Action Needed Crossing Status: Found UCIP Comments: May need cleaning the pipe. FIELD_STRUCT_DESC: 30-inch corrugated metal drainage pipe through the levee, 6 feet below the crown. Concrete U-shaped headwalls on both ends. Flap gate on the waterside (WS) end. Grouted inlet and outlet. [Additional Reference(s): DWR Levee Log, 1992, 36-inch pipe listed. USACE San Joaquin O&M Manual 611.1, Volume F, (HLM 0.54)]. FS Date: 4/4/2014

WS view: CM pipe, flapgate, and concrete headwall on levee slope.
