**Flood Control Project Maintenance  
Levee Inspections**

**Maintenance Issue Types Only, Levee Inspection Report By Mile - Fall 2018**

**San Joaquin County Flood Control and Water Conservation District**

Waterway	Bank	Unit Miles	Inspection Start/End	Inspector
Unit No. 01 Littlejohn Creek	Left	2.59	10/18/2018 10/18/2018	Wade Wylie

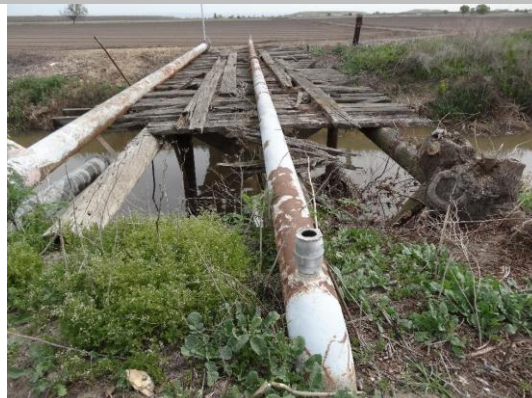
Photo 2 of 3 : UCIP\_FA\_2018\_32744\_59244.jpg

WS view: 8-inch steel pipe (right) and 12-inch steel pipe (left) over Little John's Creek on wooden structure.

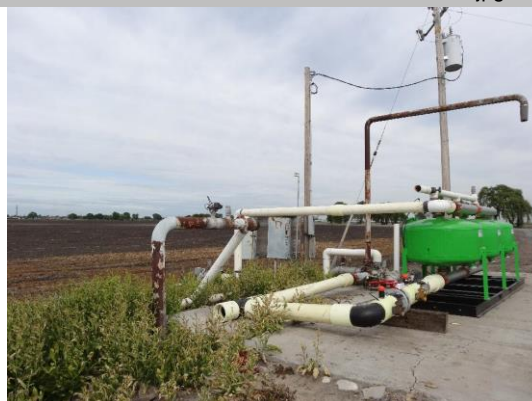
Photo 3 of 3 : UCIP\_FA\_2018\_32744\_59243.jpg

LS view: water filtration plant on concrete pad.

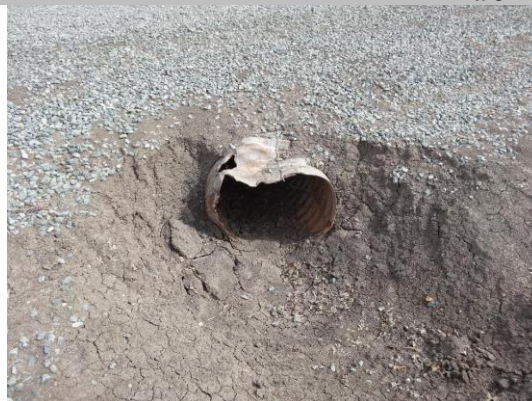
Photo 2 of 3 : UCIP\_FA\_2018\_53494\_59247.jpg

FS\_ID:53494  
DS\_ID:17973  
EP\_NO: N/A  
Repair Type: Urgent  
Crossing Status: Found  
UCIP Comments: 11/02/2018 Inlet deformed. Outlet missing a slide gate. The LMA states that a new slide gate will be installed in about two weeks. Inlet and outlet have dirt and vegetation issues. Crossing remains "Urgent" until a new slide gate is installed. Contact the LMA to see if they have photographic evidence that a new slide gate was put in. (A. McDonald - DWR UCIP)10/18/2018 Inlet deformed. Outlet missing a slide gate. This means that the pipe cannot be closed during high water. I have escalated this crossing from "No Action Needed" to "Urgent" due to the straight through pipe which could cause flooding during high water. There is a hole in the inlet, due to the deformity. It was most likely ran over by heavy equipment. I do not see enough evidence for an internal pipe inspection. (A. McDonald - DWR UCIP)03/25/2014 May need cleaning of mud in inlet pipe. (W. Wylie - DWR UCIP)

LS view: deformed CMP inlet on a drainage ditch.

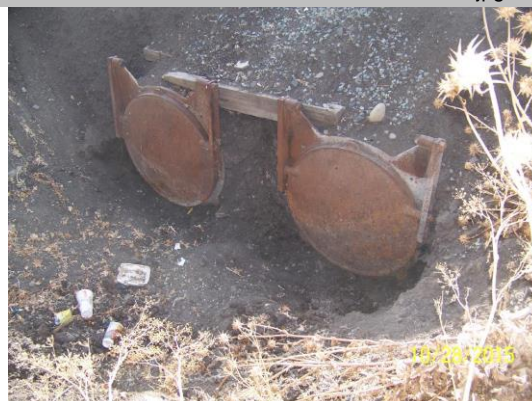
Photo 1 of 3 : UCIP\_FA\_2018\_53461\_74752.jpg

Comment Code					
Inspector Comment					
FS_ID:53461 DS_ID:17972 EP_NO: N/A Repair Type: No Action Needed Crossing Status: Found UCIP Comments: 11/02/2018 Inlet and outlet cleared of dirt by the LMA. Crossing has been downgraded to "No Action Needed." (A. McDonald - DWR UCIP)03/25/2014 LS vegetation debris and mud on the inlet ditch and inside the pipe. (P. Amatya - DWR UCIP) FIELD_STRUCT_DESC: 1 of 2: 36-inch corrugated metal drainage pipe through the levee, 6.6 feet below the crown. Flap gate on the waterside (WS) end. [Additional Reference(s): DWR Levee Log, 1977. USACE San Joaquin O&M Manual 613C, Volume 15, May 1963 (Station 94+40)]. FS Date: 11/2/2018 3:23:00 PM

WS: Debris blocking flap gate has been cleared per FPIIB Inspector email 11/16/2015

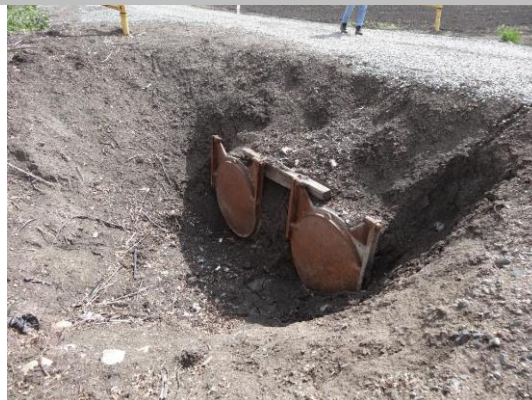
Photo 2 of 3 : UCIP\_FA\_2018\_53461\_59185.jpg

WS view: CMP drain pipes with flap gates on ditch.

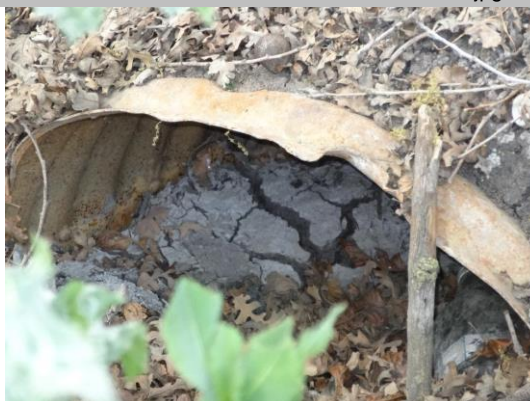
Photo 3 of 3 : UCIP\_FA\_2018\_53459\_59249.jpg

Item	DWR UCIP LMA Responsibility			37.877566 °	37.877566 °	
				-121.246391 °	-121.246391 °	
DWR ID	23985					
Comment Code						
Inspector Comment						
FS_ID:53459 DS_ID:23985 EP_NO: N/A Repair Type: No Action Needed Crossing Status: Found UCIP Comments: 11/02/2018 Inlet and outlet cleared of dirt and vegetation by the LMA. Crossing has been downgraded to "No Action Needed." (A. McDonald - DWR UCIP)03/25/2014 Debris and mud on inlet ditch and inside pipe. Needs cleaning and clearing the culvert. (P. Amatya - DWR UCIP) FIELD_STRUCT_DESC: 30-inch corrugated metal drainage pipe through the levee, 11 feet below the crown. Flap gate on the waterside (WS). [Additional Reference(s): USACE San Joaquin O&M Manual 613C, Volume 15, May 1963, (Station 83+00)]. FS Date: 11/2/2018 2:31:00 PM

LS view: inside view of CM inlet pipe. Needs cleaning and clearing the culvert.

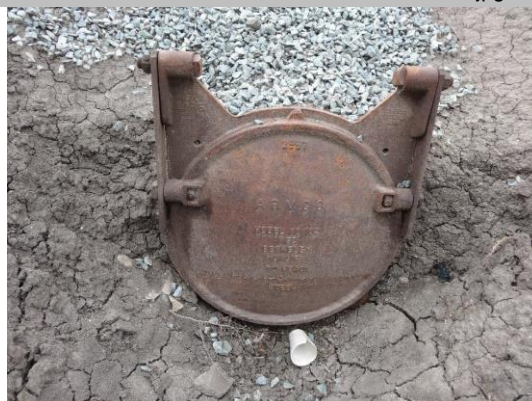
Photo 2 of 3 : UCIP\_FA\_2018\_53458\_59253.jpg

WS view: closer view of CM drain pipe with flap gate on levee slope.

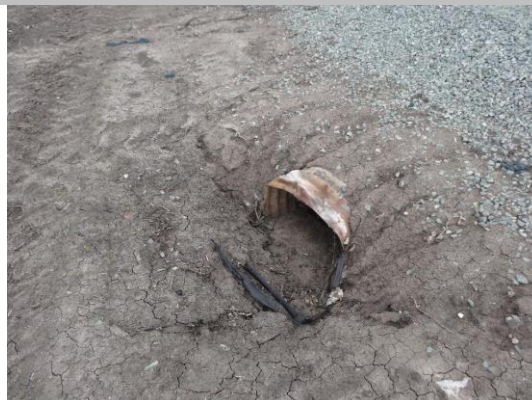
Photo 3 of 3 : UCIP\_FA\_2018\_53458\_59252.jpg

Comment Code						
Inspector Comment						
FS_ID:53458 DS_ID:17970 EP_NO: N/A Repair Type: Non-Urgent Crossing Status: Found UCIP Comments: 11/02/2018 Inlet still deformed. Inlet and outlet cleared of dirt and vegetation by the LMA. Crossing continues to be rated "Non-Urgent." (A. McDonald - DWR UCIP)03/25/2014 Needs cleaning and clearing the culvert. (P. Amatya - DWR UCIP) FIELD_STRUCT_DESC: 24-inch corrugated metal drainage pipe through the levee, 4.1 feet below the crown. Flap gate on the waterside (WS) end. [Additional Reference(s): DWR Levee Log, 1977. USACE San Joaquin O&M Manual 613C, Volume 15, May 1963, (Station 76+60)]. FS Date: 11/2/2018 2:22:00 PM

LS view: deformed CM inlet pipe on levee slope. Debris and mud on inlet ditch.

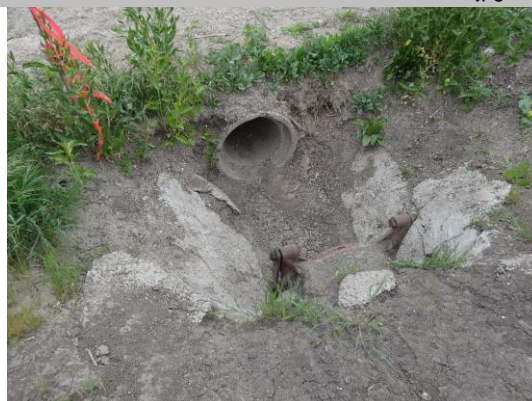
Photo 1 of 3 : UCIP\_FA\_2018\_53462\_59121.jpg

Comment Code						
Inspector Comment						
FS_ID:53462						
DS_ID:17966						
EP_NO: N/A						
Repair Type: No Action Needed						
Crossing Status: Found						
UCIP Comments: 11/02/2018 Inlet uncovered from the dirt by the LMA.						
Some vegetation at the flap gate. Crossing continues to be rated "No						
Action Needed." (A. McDonald - DWR UCIP)03/25/2014 Grouted						
riprap outlet box and concrete outfall pipe on waterside. Pipe not visible						
on landside. (P. Amatya - DWR UCIP)						
FIELD_STRUCT_DESC: 24-inch corrugated metal drainage pipe						
through the levee, 5 feet below the crown. Flap gate on the waterside						
(WS) end. Grouted riprap outlet box and concrete outfall pipe on the						
WS. [Additional Reference(s): DWR Levee Log, 1977. USACE San						
Joaquin O&M Manual 613C, Volume 15, May 1963, (Station 4+00)].						
FS Date: 11/2/2018 3:43:00 PM

WS view: outlet box, CMP with flapgate (bottom), and concrete outfall pipe (Top).

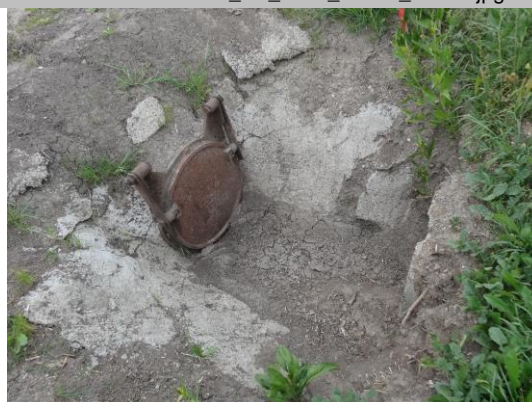
Photo 2 of 3 : UCIP\_FA\_2018\_53462\_59120.jpg

WS view: outlet pipe with flap gate. Grouted riprap on spillway.

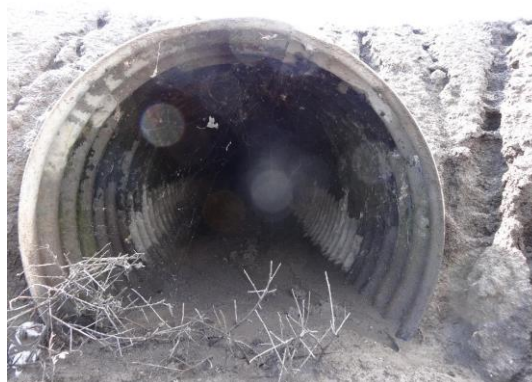
Photo 3 of 3 : UCIP\_FA\_2018\_53457\_59929.jpg

Comment Code						
Inspector Comment						
FS_ID:53457						
DS_ID:17986						
EP_NO: N/A						
Repair Type: No Action Needed						
Crossing Status: Found						
UCIP Comments: 11/02/2018 Inlet cleared of dirt and vegetation by the						
LMA. Crossing continues to be rated "No Action Needed." (A.						
McDonald - DWR UCIP)04/02/2014 May need cleaning. (P. Amatya -						
DWR UCIP)						
FIELD_STRUCT_DESC: 24-inch corrugated metal drainage pipe						
through the levee, 5 feet below the crown. Flap gate on the waterside						
(WS) end. [Additional Reference(s): DWR Levee Log, 1977. USACE						
San Joaquin O&M Manual 613C, Volume 15, May 1963, (Station						
148+18N)].						
FS Date: 11/2/2018 2:16:00 PM

LS view: closer view of CM inlet pipe. Mud on inlet ditch and pipe. May need cleaning.

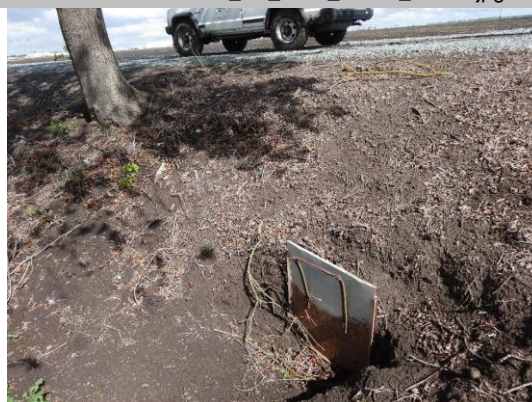
Photo 1 of 3 : UCIP\_FA\_2018\_53453\_59937.jpg

Comment Code						
Inspector Comment						
FS_ID:53453 DS_ID:17983 EP_NO: N/A Repair Type: No Action Needed Crossing Status: Found UCIP Comments: 11/02/2018 Inlet and outlet cleared of dirt and vegetation by the LMA. Crossing has been downgraded to "No Action Needed." (A. McDonald - DWR UCIP)04/02/2014 Needs cleaning and clearing the culvert. (P. Amatya - DWR UCIP) FIELD_STRUCT_DESC: 24-inch corrugated metal drainage pipe through the levee, 6.4 feet below the crown. Flap gate on the waterside (WS) end. [Additional Reference(s): DWR Levee Log, 1977. USACE San Joaquin O&M Manual 613C, Volume 15, May 1963, (Station 114+50)]. FS Date: 11/2/2018 11:37:00 AM

WS view: CM drain pipe with plate gate on levee slope.

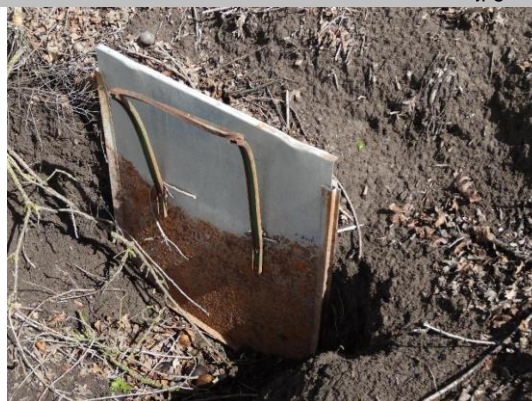
Photo 2 of 3 : UCIP\_FA\_2018\_53453\_59936.jpg

WS view: closer view of plate gate on the CM pipe end.

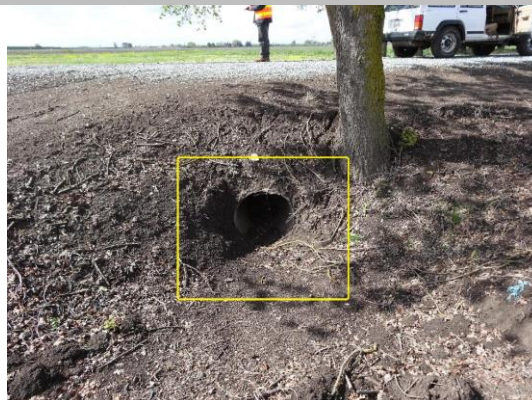
Photo 3 of 3 : UCIP\_FA\_2018\_53453\_59938.jpg

LS view: CM inlet pipe on levee slope.

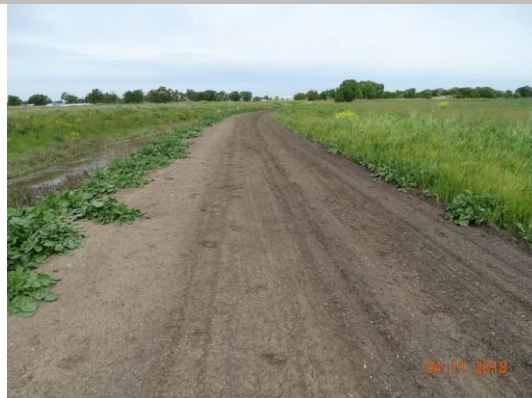
Photo 1 of 1 : FA\_2018\_NA0017\_149\_19\_20181002\_00003.jpg

LM Start	2.18	Rating **	A/W	Issue No.	19
LM End	2.44	Issue Type +	Ma	Location *	CR
Category	Earthen Levee			GPS Latitude/Longitude	
				Start	End
Item	Crown Surface / Depressions / Rutting			37.884195°	37.887440°
				-121.253349°	-121.255540°
DWR ID	DWR_NA0017_02_s_2018_19				
Comment Code					
C1 : Add appropriate material and re-grade the levee to bring the crown above the design elevation.					
Inspector Comment					
This portion is non-project levee. This could potentially impact patrol road access and therefore is rated as A/W.

Repair crown surface looking west.

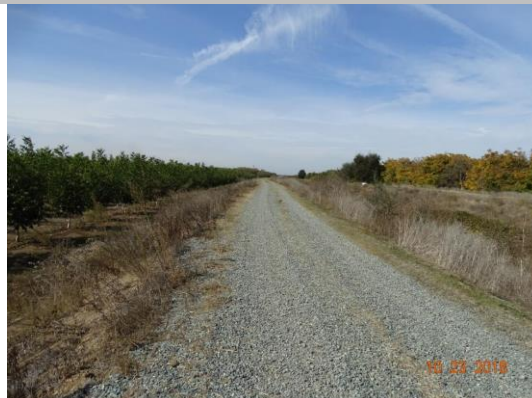
Photo 1 of 1 : FA\_2018\_NA0017\_150\_3\_20181025\_00007.jpg

LM Start	0.01	Rating **	U	Issue No.	3
LM End	0.46	Issue Type +	Ma	Location *	WS
Category	Earthen Levee			GPS Latitude/Longitude	
				Start	End
Item	Vegetation			37.979172°	37.979342°
				-121.098682°	-121.090400°
DWR ID	DWR_NA0017_06_f_2018_3				
Comment Code					
V1 : Control annual grass and weeds on the levee slopes and easements.					
Inspector Comment					
Maintain vegetation on water side slope

View looking downstream (October 2018).

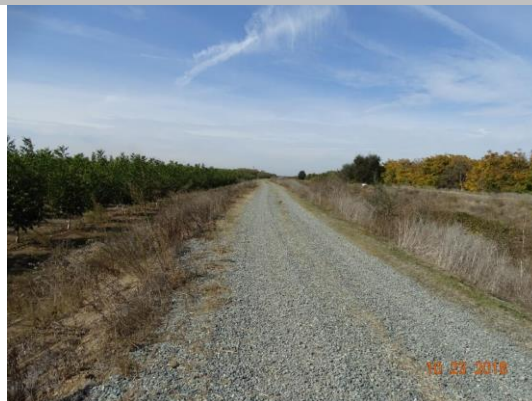
Photo 1 of 1 : FA\_2018\_NA0017\_150\_2\_20181025\_00008.jpg

LM Start	0.24	Rating **	M	Issue No.	2
LM End	0.46	Issue Type +	Ma	Location *	LS
Category	Earthen Levee			GPS Latitude/Longitude	
				Start	End
Item	Vegetation			37.979247°	37.979342°
				-121.094478°	-121.090400°
DWR ID	DWR_NA0017_06_f_2018_2				
Comment Code					
V1 : Control annual grass and weeds on the levee slopes and easements.					
Inspector Comment					
Maintain vegetation on land side slope

View looking downstream (October 2018)

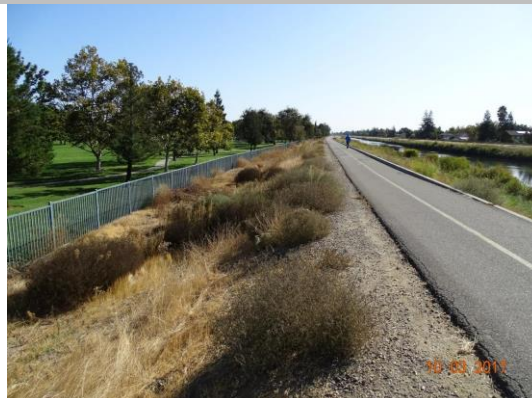
Photo 1 of 1 : FA\_2018\_NA0017\_151\_69\_20180926\_00023.jpg

LM Start	0.38	Rating **	M	Issue No.	69
LM End	1.31	Issue Type +	Ma	Location *	LS
Category	Earthen Levee			GPS Latitude/Longitude	
				Start	End
Item	Vegetation			38.043596 °	38.043274 °
				-121.366714 °	-121.349704 °
DWR ID	DWR_NA0017_07_s_2017_69				
Comment Code					
V2 : Remove the wild growth other than native grasses from the levee slopes.					
Inspector Comment

View of vegetation on the landside of the levee looking upstream. Fall 2017

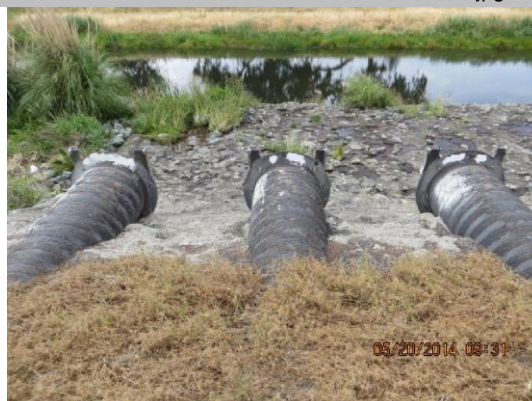
Photo 1 of 2 : UCIP\_FA\_2018\_38088\_69295.jpg

Pipe and flapgate on WS slope.

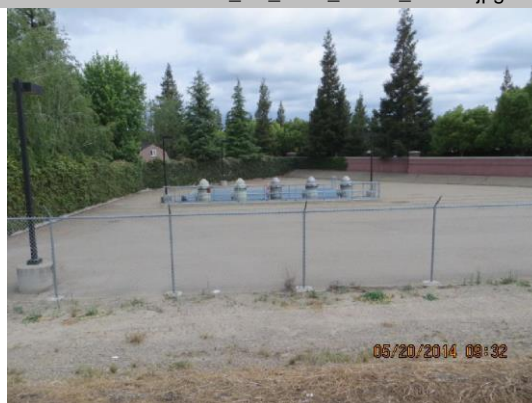
Photo 2 of 2 : UCIP\_FA\_2018\_38088\_69294.jpg

Pump over sump off LS toe.

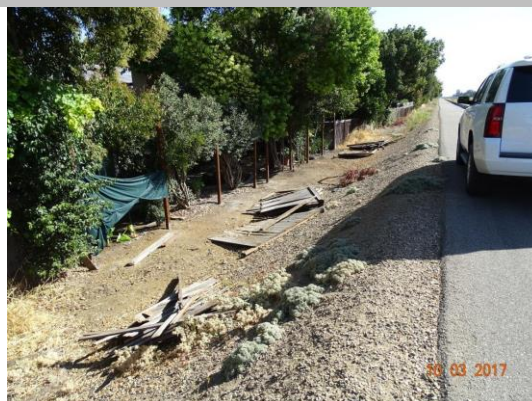
Photo 1 of 1 : FA\_2018\_NA0017\_151\_141\_20180926\_00033.jpg

LM Start	1.55	Rating **	M	Issue No.	141
LM End	1.55	Issue Type +	Ma	Location *	LS
Category	Earthen Levee			GPS Latitude/Longitude	
				Start	End
Item	Encroachments			38.043300°	38.043300°
				-121.345242°	-121.345242°
DWR ID	DWR_NA0017_07_f_2017_141				
Comment Code					
DE : Debris					
Inspector Comment					
Fence material at the landside toe.

View of debris on the landside slope of the levee looking upstream. Fall 2017

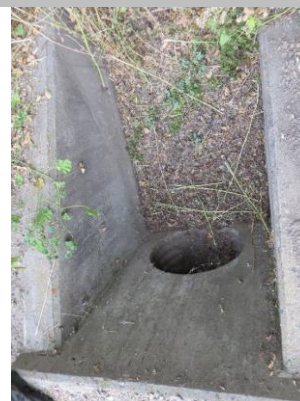
Photo 3 of 3 : UCIP\_FA\_2018\_38024\_69203.jpg

Headwall at LS toe.

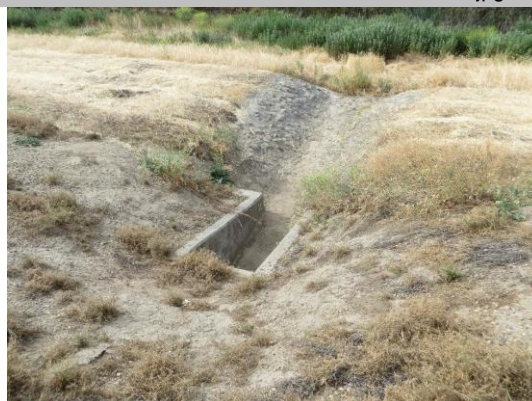
Photo 1 of 3 : UCIP\_FA\_2018\_38006\_69190.jpg

Headwall, flapgate, and grouted spillway on WS toe.

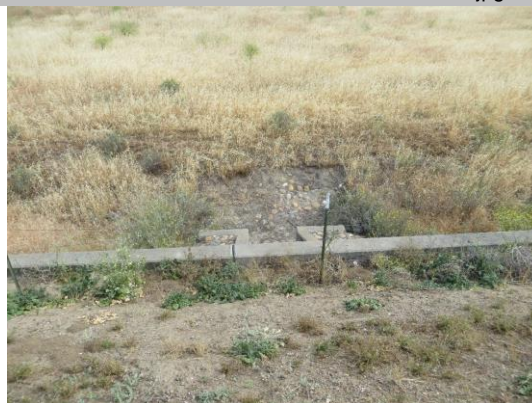
Photo 2 of 3 : UCIP\_FA\_2018\_38006\_69189.jpg

Headwall at inlet on LS toe.

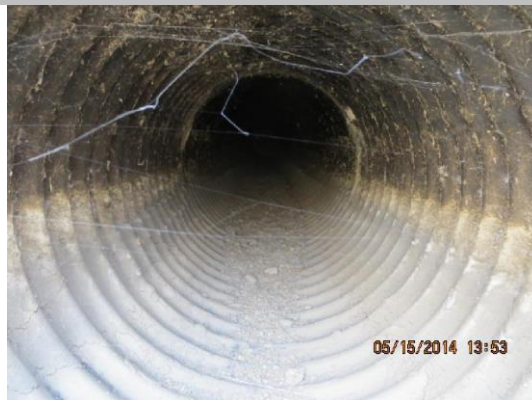
Photo 2 of 3 : UCIP\_FA\_2018\_37999\_69163.jpg

Inside pipe at LS toe.

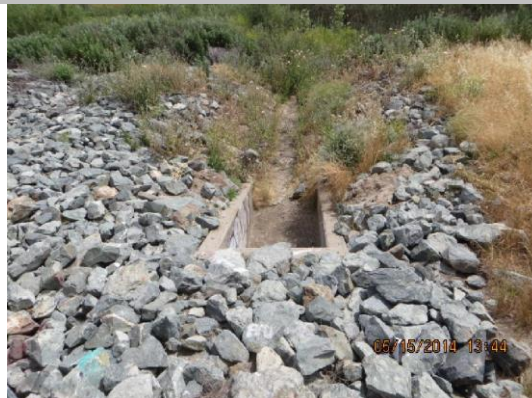
Photo 2 of 3 : UCIP\_FA\_2018\_37998\_69159.jpg

Headwall and flapgate on WS toe.

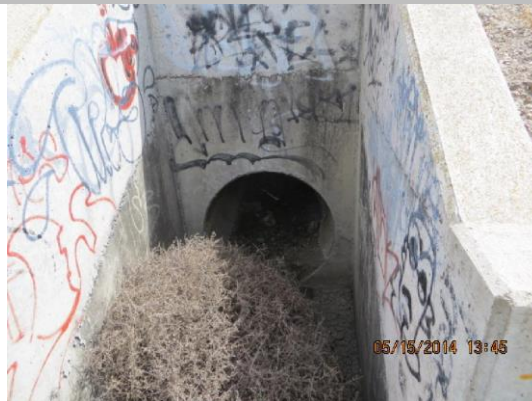
Photo 3 of 3 : UCIP\_FA\_2018\_37998\_69158.jpg

Headwall on LS slope.

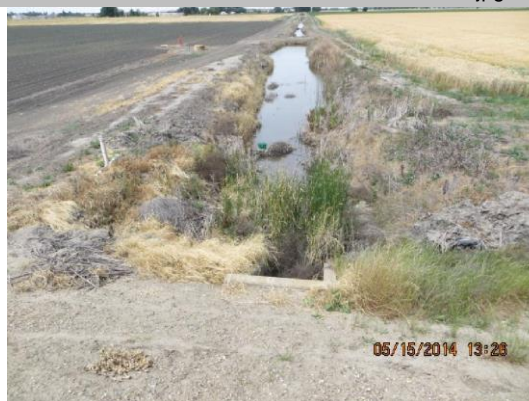
Photo 1 of 3 : UCIP\_FA\_2018\_37991\_69144.jpg

LM Start	3.27	Rating **	A/W	Issue No.	1071
LM End	3.27	Issue Type +	Ma	Location *	
Category	Supplemental			GPS Latitude/Longitude	
				Start	End
Item	DWR UCIP LMA Responsibility			38.043193 °	38.043193 °
				-121.313684 °	-121.313684 °
DWR ID	23532				
Comment Code					
Inspector Comment					
FS_ID:37991					
DS_ID:23532					
EP_NO: N/A					
Repair Type: No Action Needed					
Crossing Status: Found					
UCIP Comments:					
FIELD_STRUCT_DESC: 36-inch corrugated metal drainage pipe through the levee, 8.5 feet below the crown. Concrete U-shaped headwalls on both ends. Flap gate on the waterside (WS) end. Cobble grouted spillway across berm. [Additional Reference(s): DWR Levee Log, 1987. USACE San Joaquin O&M Manual 612.1, June 1965, (HLM 3.58)].					
FS Date: 5/15/2014

Headwall at LS toe.

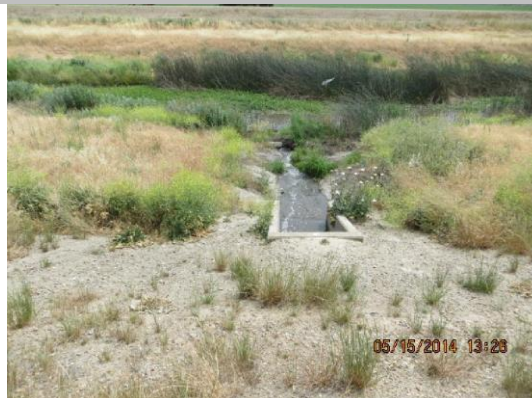
Photo 2 of 3 : UCIP\_FA\_2018\_37991\_69143.jpg

Headwall and flapgate at WS toe.

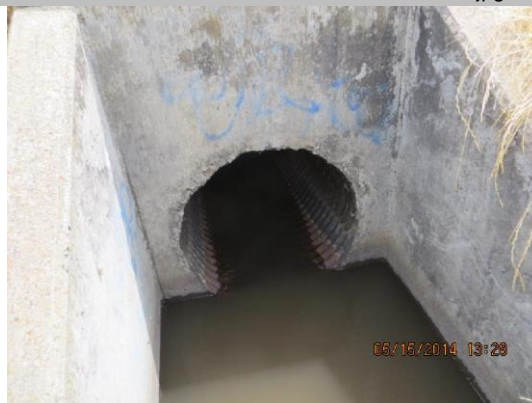
Photo 3 of 3 : UCIP\_FA\_2018\_37991\_69142.jpg

Headwall at LS toe.

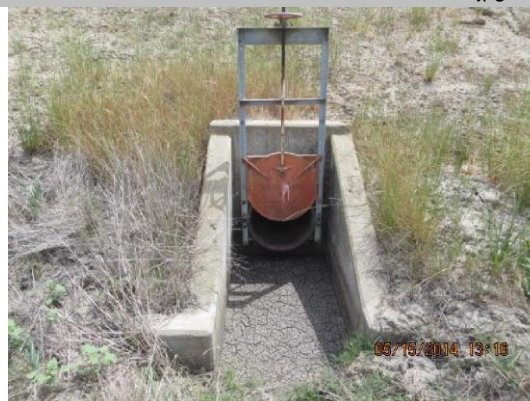
Photo 3 of 3 : UCIP\_FA\_2018\_37988\_69137.jpg

Headwall and slidegate on LS toe.

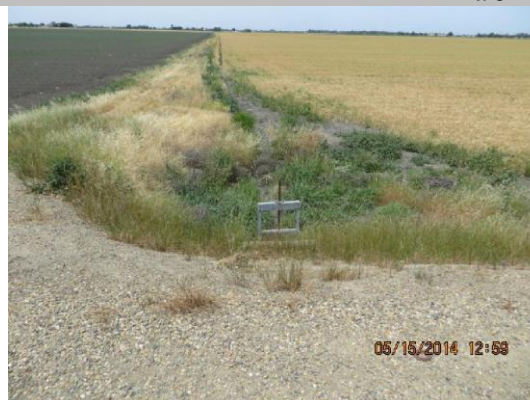
Photo 1 of 3 : UCIP\_FA\_2018\_37984\_69129.jpg

LM Start	3.78	Rating **	A/W	Issue No.	1073
LM End	3.78	Issue Type +	Ma	Location *	
Category	Supplemental			GPS Latitude/Longitude	
				Start	End
Item	DWR UCIP LMA Responsibility			38.042997 °	38.042997 °
				-121.304345 °	-121.304345 °
DWR ID	23534				
Comment Code					
Inspector Comment					
FS_ID:37984 DS_ID:23534 EP_NO: N/A Repair Type: No Action Needed Crossing Status: Found UCIP Comments: FIELD_STRUCT_DESC: 24-inch corrugated metal storm drainage pipe through the levee, 7 feet below the crown. Concrete U-shaped headwalls on both ends. Flap gate on the waterside (WS) end. Slide gate on the landside (LS) end. Grouted intake on the LS. Cobble grouted spillway across the berm. [Additional Reference(s): DWR Levee Log, 1987. USACE San Joaquin O&M Manual 612.1, June 1965, (HLM 4.10) and 612 (addendum), February 1999, (HLM 4.10) (Station 216+43)]. FS Date: 5/15/2014

Slidegate at headwall on LS toe.

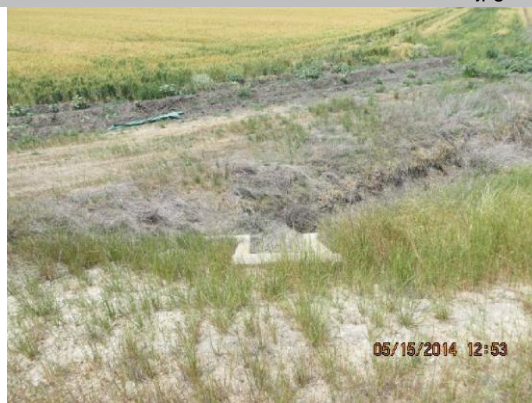
Photo 1 of 3 : UCIP\_FA\_2018\_37982\_69125.jpg

LM Start	4.05	Rating **	A/W	Issue No.	1074
LM End	4.05	Issue Type +	Ma	Location *	
Category	Supplemental			GPS Latitude/Longitude	
				Start	End
Item	DWR UCIP LMA Responsibility			38.043975 °	38.043975 °
				-121.299901 °	-121.299901 °
DWR ID	23535				
Comment Code					
Inspector Comment					
FS_ID:37982					
DS_ID:23535					
EP_NO: N/A					
Repair Type: No Action Needed					
Crossing Status: Found					
UCIP Comments:					
FIELD_STRUCT_DESC: 24-inch corrugated metal storm drainage pipe through the levee, 8 feet below the crown. Concrete U-shaped headwalls on both ends. Flap gate on the waterside (WS) end. Grouted intake on the landside (LS). Cobble grouted spillway across the berm. [Additional Reference(s): DWR Levee Log, 1987. USACE San Joaquin O&M Manual 612.1, June 1965, (HLM 4.37) and 612 (addendum), February 1999, (HLM 4.33) (Station 228+58)].					
FS Date: 5/15/2014

Headwall at LS toe.

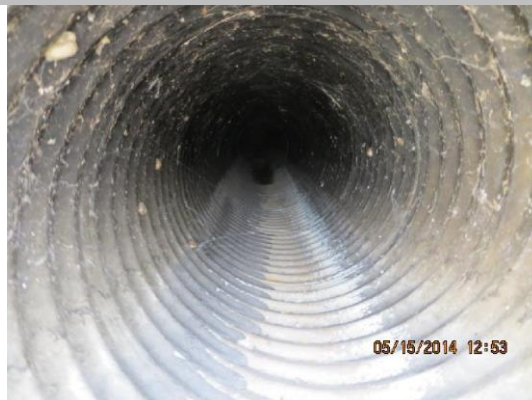
Photo 3 of 3 : UCIP\_FA\_2018\_37982\_69123.jpg

Inside pipe at LS toe.

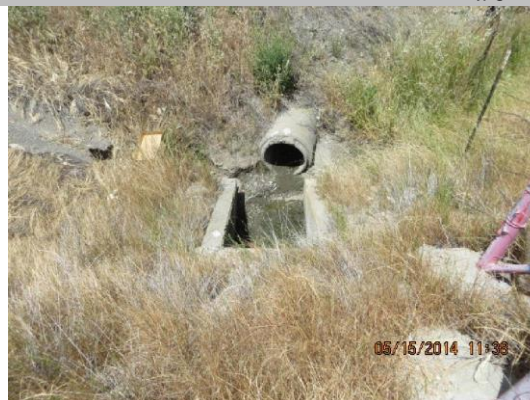
Photo 1 of 3 : UCIP\_FA\_2018\_37973\_69105.jpg

LM Start	4.33	Rating **	A/W	Issue No.	1077
LM End	4.33	Issue Type +	Ma	Location *	
Category	Supplemental			GPS Latitude/Longitude	
				Start	End
Item	DWR UCIP LMA Responsibility			38.044917 °	38.044917 °
				-121.295062 °	-121.295062 °
DWR ID	23538				
Comment Code					
Inspector Comment					
FS_ID:37973					
DS_ID:23538					
EP_NO: N/A					
Repair Type: No Action Needed					
Crossing Status: Found					
UCIP Comments:					
FIELD_STRUCT_DESC: 24-inch corrugated metal drainage pipe through the levee, 8.3 feet below the crown. Concrete U-shaped headwalls on both ends. Flap gate on the waterside (WS) end. Grouted intake on the landside (LS). Cobble grouted spillway across berm. [Additional Reference(s): DWR Levee Log, 1987. USACE San Joaquin O&M Manual 612.1, June 1965, (HLM 4.66)].					
FS Date: 5/15/2014

Headwall on LS toe.

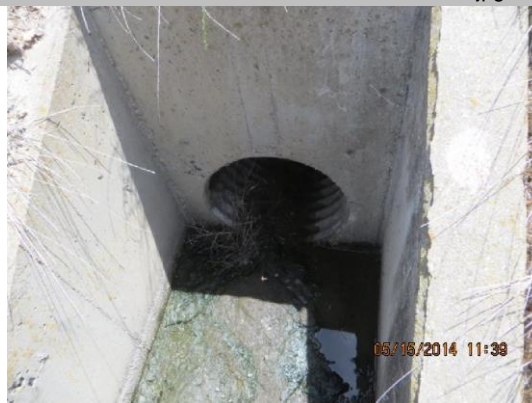
Photo 3 of 3 : UCIP\_FA\_2018\_37973\_69103.jpg

Headwall on LS toe.

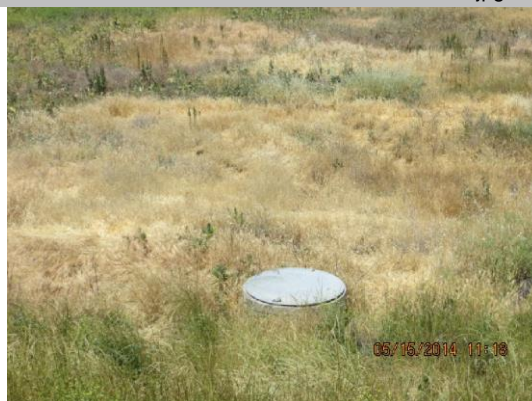
Photo 1 of 3 : UCIP\_FA\_2018\_37967\_69085.jpg

Comment Code						
Inspector Comment						
FS_ID:37967						
DS_ID:23540						
EP_NO: N/A						
Repair Type: No Action Needed						
Crossing Status: Found						
UCIP Comments:						
FIELD_STRUCT_DESC: 24-inch corrugated metal storm drainage pipe through the levee, 8.8 feet below the crown. 44-inch concrete standpipe on the landside (LS) toe. Concrete U-shaped headwall on the waterside (WS) end. Flap gate on the WS end. Cobble grouted spillway across the berm. [Additional Reference(s): DWR Levee Log, 1987. USACE San Joaquin O&M Manual 612.1, June 1965, (HLM 4.88) and 612 (addendum), February 1999, (HLM 4.88) (Station 257+60)].						
FS Date: 5/15/2014

Concrete standpipe on LS toe.

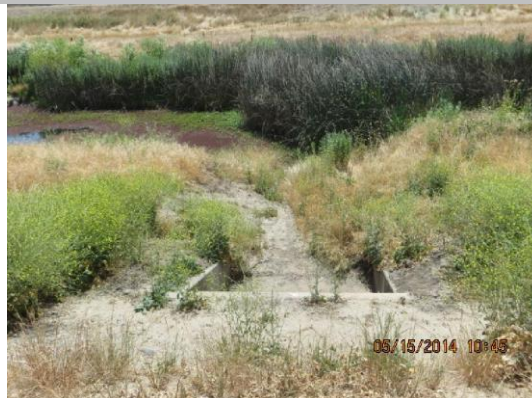
Photo 2 of 3 : UCIP\_FA\_2018\_37957\_69054.jpg

LM Start	4.97	Rating **	A/W	Issue No.	1080 (cont)
LM End	4.97	Issue Type +	Ma	Location *	
Category	Supplemental			GPS Latitude/Longitude	
				Start	End
Item	DWR UCIP LMA Responsibility			38.050685 °	38.050685 °
				-121.286569 °	-121.286569 °
DWR ID	23543				
Comment Code					
Inspector Comment					
FS_ID:37957 DS_ID:23543 EP_NO: N/A Repair Type: No Action Needed Crossing Status: Found UCIP Comments: FIELD_STRUCT_DESC: 1 of 2: 36-inch corrugated metal storm drainage pipe through the levee, 8.9 feet below the crown. Concrete U-shaped headwall on both ends. Flap gate on the waterside (WS) end. Grouted intake on the landside (LS). Cobble grouted spillway across the berm. [Additional Reference(s): DWR Levee Log, 1987. USACE San Joaquin O&M Manual 612.1, June 1965, (HLM 5.33) and 612 (addendum), February 1999, (HLM 5.37) (Station 283+76)]. FS Date: 5/15/2014

Headwall and flapgate on WS toe.

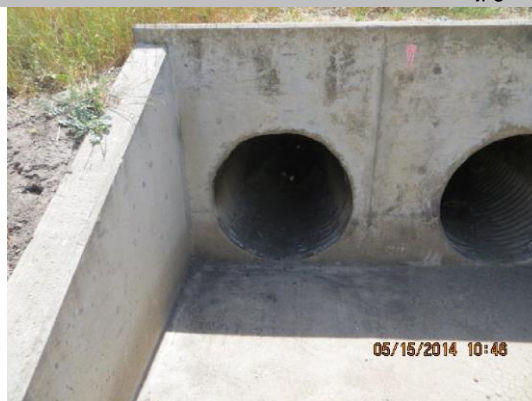
Photo 3 of 3 : UCIP\_FA\_2018\_41807\_69048.jpg

LM Start	4.97	Rating **	M	Issue No.	1081 (cont)	
LM End	4.97	Issue Type +	Ma	Location *		
Category	Supplemental			GPS Latitude/Longitude		
				Start	End	
Item	DWR UCIP LMA Responsibility			38.050700 °	38.050700 °	
				-121.286552 °	-121.286552 °	
DWR ID	23678					
Comment Code						
Inspector Comment						
FS_ID:41807						
DS_ID:23678						
EP_NO: N/A						
Repair Type: Non-Urgent						
Crossing Status: Found						
UCIP Comments: Some silt buildup in pipe.						
FIELD_STRUCT_DESC: 2 of 2: 36-inch corrugated metal drainage pipe through the levee, 8.9 feet below the crown. Concrete U-shaped headwall on both ends. Flap gate on the waterside (WS) end. Grouted intake on the landside (LS). Cobble grouted spillway across the berm. [Additional Reference(s): DWR Levee Log, 1987. USACE San Joaquin O&M Manual 612.1, June 1965, (HLM 5.33)].						
FS Date: 5/15/2014

Headwall at LS toe.

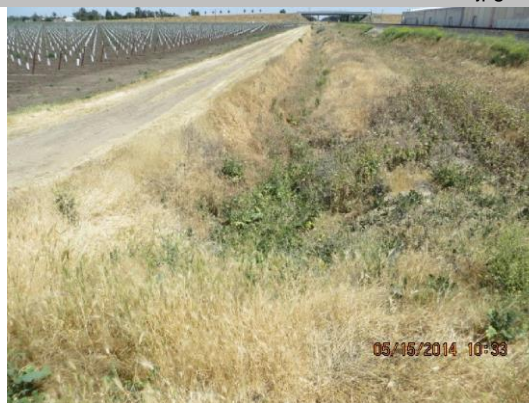
Photo 1 of 3 : UCIP\_FA\_2018\_37885\_68913.jpg

LM Start	5.50	Rating **	A/W	Issue No.	1082	
LM End	5.50	Issue Type +	Ma	Location *		
Category	Supplemental			GPS Latitude/Longitude		
				Start		End
Item	DWR UCIP LMA Responsibility			38.052790 °		38.052790 °
				-121.277636 °		-121.277636 °
DWR ID	23544					
Comment Code						
Inspector Comment						
FS_ID:37885						
DS_ID:23544						
EP_NO: N/A						
Repair Type: No Action Needed						
Crossing Status: Found						
UCIP Comments:						
FIELD_STRUCT_DESC: 36-inch corrugated metal storm drainage pipe through the levee, 10.6 feet below the crown. Concrete U-shaped headwall on the waterside (WS) end. Flap gate on the WS end. Cobble grouted spillway across the berm. [Additional Reference(s): DWR Levee Log, 1987. USACE San Joaquin O&M Manual 612.1, June 1965, (HLM 5.87) and 612 (addendum), February 1999, (HLM 5.81) (Station 306+88)].						
FS Date: 5/15/2014

Pipe in channel on LS toe.

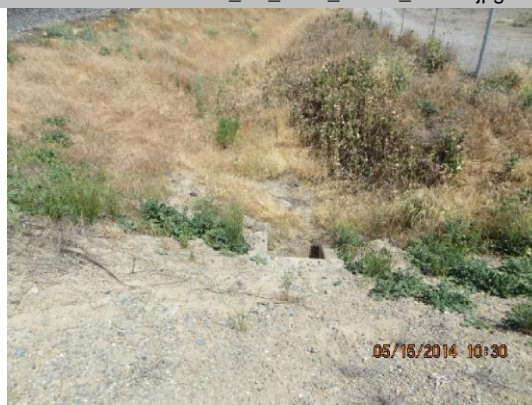
Photo 2 of 3 : UCIP\_FA\_2018\_41801\_68901.jpg

Headwall on LS toe.

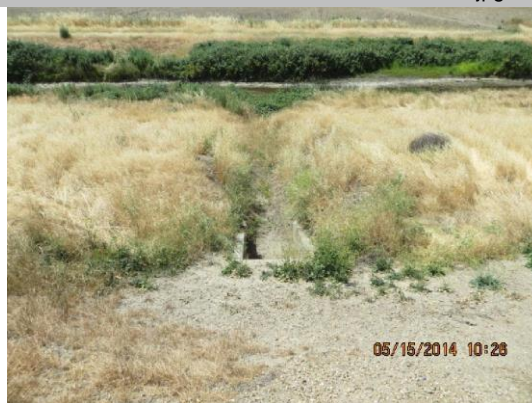
Photo 1 of 2 : UCIP\_FA\_2018\_40213\_68899.jpg

Comment Code						
Inspector Comment						
FS_ID:40213						
DS_ID:23546						
EP_NO: N/A						
Repair Type: Non-Urgent						
Crossing Status: Found						
UCIP Comments: Inlet burried at LS toe. Pipe may be abandoned and if so should be done so properly.						
FIELD_STRUCT_DESC: *ABANDONED* 36-inch corrugated metal drainage pipe through the levee, 7.9 feet below the crown. Concrete U-shaped headwall on the waterside (WS) end. Concrete headwall on the landside (LS). Flap gate on the WS end. Cobble grouted spillway across the berm. [Additional Reference(s): DWR Levee Log, 1987. USACE San Joaquin O&M Manual 612.1, June 1965, (HLM 5.97)].						
FS Date: 5/15/2014

Headwall and flapgate at WS toe.

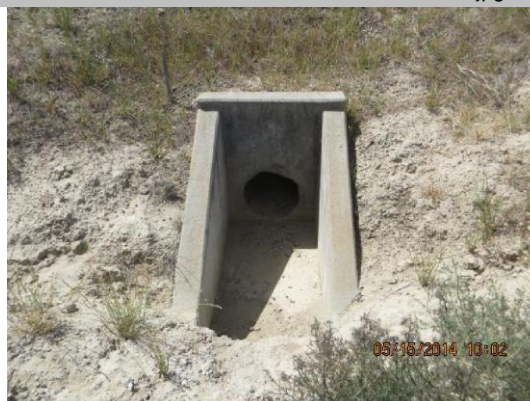
Photo 3 of 3 : UCIP\_FA\_2018\_41802\_68883.jpg

Comment Code						
Inspector Comment						
FS_ID:41802						
DS_ID:23551						
EP_NO: N/A						
Repair Type: Non-Urgent						
Crossing Status: Found						
UCIP Comments: Sediment buildup in pipe at LS toe.						
FIELD_STRUCT_DESC: 24-inch corrugated metal storm drainage pipe through the levee, 5.5 feet below the crown. Concrete U-shaped headwalls on both ends. Flap gate on the waterside (WS) end. Grouted intake on the landside (LS). Cobble grouted spillway across the berm. [Additional Reference(s): DWR Levee Log, 1987. USACE San Joaquin O&M Manual 612.1, June 1965, (HLM 6.32) and 612 (addendum), February 1999, (HLM 6.34) (Station 334+54), listed as a 36-inch pipe]. FS Date: 5/15/2014

Headwall on LS toe.

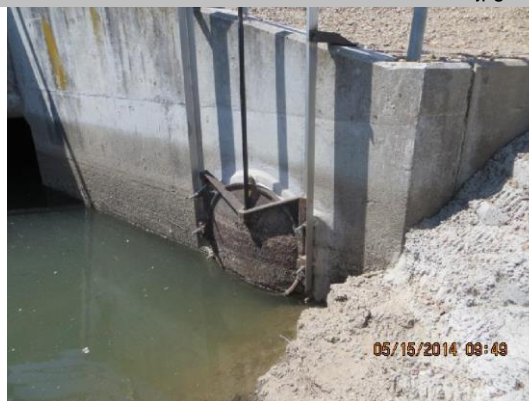
Photo 3 of 3 : UCIP\_FA\_2018\_40208\_68879.jpg

Item	DWR UCIP LMA Responsibility			38.054467 °	38.054467 °	
				-121.266715 °	-121.266715 °	
DWR ID	23552					
Comment Code						
Inspector Comment						
FS_ID:40208						
DS_ID:23552						
EP_NO: N/A						
Repair Type: No Action Needed						
Crossing Status: Found						
UCIP Comments:						
FIELD_STRUCT_DESC: 24-inch corrugated metal storm drainage pipe through the levee, 6.4 feet below the crown. Concrete U-shaped headwall on the waterside (WS) end. Flap gate on the WS end. Cobble grouted spillway across the berm. Slide gate on the landside (LS) end. [Additional Reference(s): DWR Levee Log, 1987. USACE San Joaquin O&M Manual 612.1, June 1965, (HLM 6.51) and 612 (addendum), February 1999, (HLM 6.51) (Station 343+82)].						
FS Date: 5/15/2014

Slide gate on headwall at pipe on LS toe.

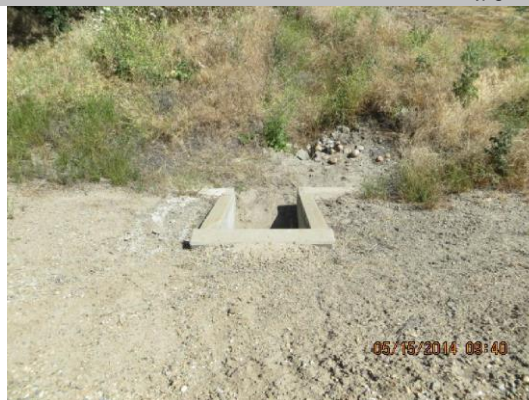
Photo 1 of 3 : UCIP\_FA\_2018\_37852\_68873.jpg

LM Start	6.13	Rating **	A/W	Issue No.	1090
LM End	6.13	Issue Type +	Ma	Location *	
Category	Supplemental			GPS Latitude/Longitude	
				Start	End
Item	DWR UCIP LMA Responsibility			38.054497 °	38.054497 °
				-121.266387 °	-121.266387 °
DWR ID	23554				
Comment Code					
Inspector Comment					
FS_ID:37852 DS_ID:23554 EP_NO: N/A Repair Type: No Action Needed Crossing Status: Found UCIP Comments: FIELD_STRUCT_DESC: 24-inch corrugated metal drainage pipe through the levee, 5.3 feet below the crown. Concrete U-shaped headwalls on both ends. Flap gate on the waterside (WS) end. Grouted intake on the landside (LS). Cobble grouted spillway across the berm. [Additional Reference(s): DWR Levee Log, 1987. USACE San Joaquin O&M Manual 612.1, June 1965, (HLM 6.53)]. FS Date: 5/15/2014

Headwall on LS toe.

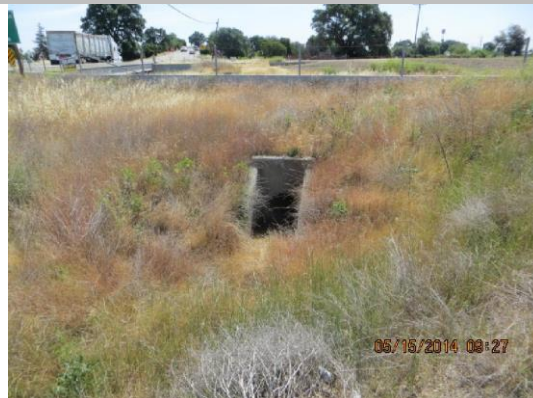
Photo 1 of 3 : UCIP\_FA\_2018\_37849\_68868.jpg

LM Start	6.44	Rating **	A/W	Issue No.	1091
LM End	6.44	Issue Type +	Ma	Location *	
Category	Supplemental			GPS Latitude/Longitude	
				Start	End
Item	DWR UCIP LMA Responsibility			38.057275 °	38.057275 °
				-121.262193 °	-121.262193 °
DWR ID	23555				
Comment Code					
Inspector Comment					
FS_ID:37849 DS_ID:23555 EP_NO: N/A Repair Type: No Action Needed Crossing Status: Found UCIP Comments: FIELD_STRUCT_DESC: 24-inch corrugated metal drainage pipe through the levee, 6.7 feet below the crown. Concrete U-shaped headwalls on both ends. Flap gate on the waterside (WS) end. Grouted intake on the landside (LS). Cobble grouted spillway across the berm. [Additional Reference(s): DWR Levee Log, 1987. USACE San Joaquin O&M Manual 612.1, June 1965, (HLM 6.85)]. FS Date: 5/15/2014

Pipe and headwall on LS toe.

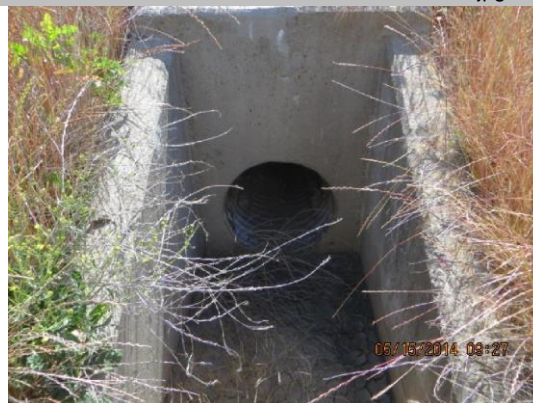
Photo 2 of 3 : UCIP\_FA\_2018\_37849\_68867.jpg

Pipe and headwall on LS toe.

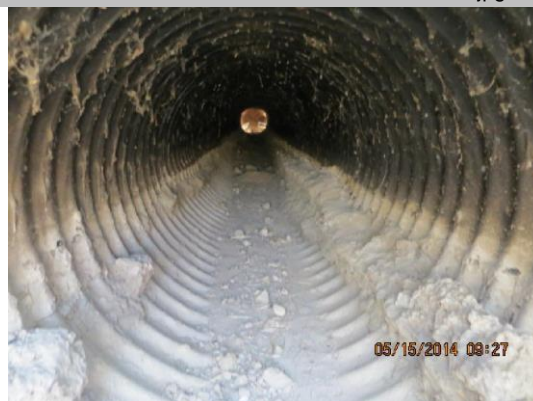
Photo 3 of 3 : UCIP\_FA\_2018\_37849\_68866.jpg

LM Start	6.44	Rating **	A/W	Issue No.	1091 (cont)
LM End	6.44	Issue Type +	Ma	Location *	
Category	Supplemental			GPS Latitude/Longitude	
				Start	End
Item	DWR UCIP LMA Responsibility			38.057275 °	38.057275 °
				-121.262193 °	-121.262193 °
DWR ID	23555				
Comment Code					
Inspector Comment					
FS_ID:37849 DS_ID:23555 EP_NO: N/A Repair Type: No Action Needed Crossing Status: Found UCIP Comments: FIELD_STRUCT_DESC: 24-inch corrugated metal drainage pipe through the levee, 6.7 feet below the crown. Concrete U-shaped headwalls on both ends. Flap gate on the waterside (WS) end. Grouted intake on the landside (LS). Cobble grouted spillway across the berm. [Additional Reference(s): DWR Levee Log, 1987. USACE San Joaquin O&M Manual 612.1, June 1965, (HLM 6.85)]. FS Date: 5/15/2014

Inside pipe at LS toe.

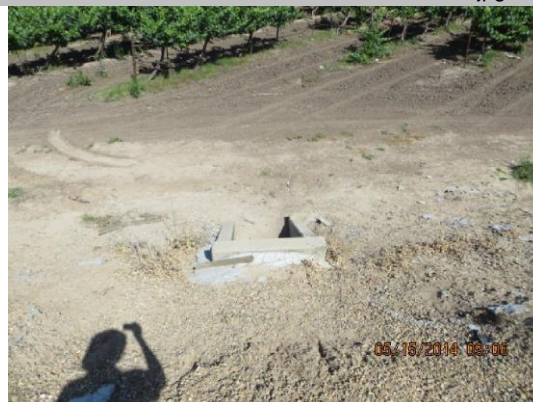
Photo 1 of 3 : UCIP\_FA\_2018\_37847\_68860.jpg

LM Start	6.62	Rating **	A/W	Issue No.	1094
LM End	6.62	Issue Type +	Ma	Location *	
Category	Supplemental			GPS Latitude/Longitude	
				Start	End
Item	DWR UCIP LMA Responsibility			38.059521 °	38.059521 °
				-121.261491 °	-121.261491 °
DWR ID	23557				
Comment Code					
Inspector Comment					
FS_ID:37847 DS_ID:23557 EP_NO: N/A Repair Type: No Action Needed Crossing Status: Found UCIP Comments: FIELD_STRUCT_DESC: 24-inch corrugated metal storm drainage pipe through the levee, 6.5 feet below the crown. Concrete U-shaped headwalls on both ends. Flap gate on the waterside (WS) end. Cobble grouted spillway across the berm. Culvert with slide gate in WID headwall on the WS. [Additional Reference(s): DWR Levee Log, 1987. USACE San Joaquin O&M Manual 612.1, June 1965, (HLM 7.02) and 612 (addendum), February 1999, (HLM 6.97) (Station 368+08)]. FS Date: 5/15/2014

Pipe and headwall on LS toe.

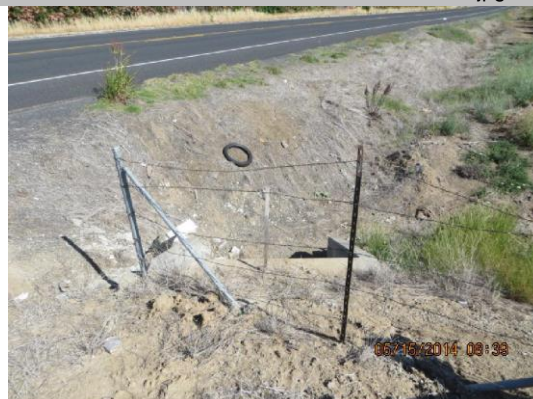
Photo 1 of 3 : UCIP\_FA\_2018\_37844\_68853.jpg

LM Start	6.82	Rating **	A/W	Issue No.	1097
LM End	6.82	Issue Type +	Ma	Location *	
Category	Supplemental			GPS Latitude/Longitude	
				Start	End
Item	DWR UCIP LMA Responsibility			38.061678 °	38.061678 °
				-121.259084 °	-121.259084 °
DWR ID	23561				
Comment Code					
Inspector Comment					
FS_ID:37844					
DS_ID:23561					
EP_NO: N/A					
Repair Type: No Action Needed					
Crossing Status: Found					
UCIP Comments:					
FIELD_STRUCT_DESC: 36-inch concrete drainage pipe through the levee, 8 feet below the crown. Concrete U-shaped headwalls on both ends. Flap gate on the waterside (WS) end. Cobble grouted spillway across berm. Cobble grouted apron on the landside (LS) end.					
[Additional Reference(s): DWR Levee Log, 1987. USACE San Joaquin O&M Manual 612.2, 1967, (HLM 7.21)].					
FS Date: 5/15/2014

Pipe and headwall on LS toe.

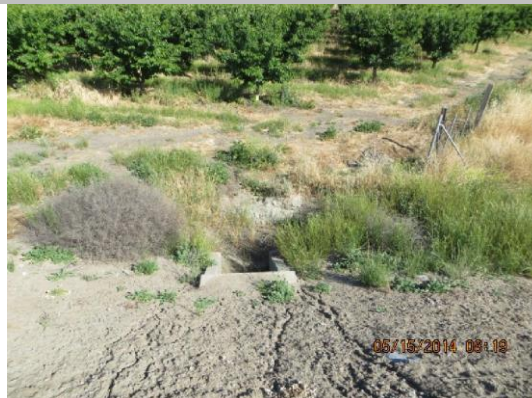
Photo 2 of 3 : UCIP\_FA\_2018\_37841\_68842.jpg

Item	DWR UCIP LMA Responsibility			38.064076 °		38.064076 °
				-121.254656 °		-121.254656 °
DWR ID	23563					
Comment Code						
Inspector Comment						
FS_ID:37841						
DS_ID:23563						
EP_NO: N/A						
Repair Type: No Action Needed						
Crossing Status: Found						
UCIP Comments:						
FIELD_STRUCT_DESC: 24-inch corrugated metal storm drainage pipe through the levee, 7 feet below the crown. Concrete U-shaped headwalls on both ends. Flap gate on the waterside (WS) end. Cobble grouted spillway across berm. Cobble grouted apron on the landside (LS) end. [Additional Reference(s): DWR Levee Log, 1987. USACE San Joaquin O&M Manual 612.2, 1967, (HLM 7.51) and 612 (addendum), February 1999, (HLM 7.45) (Station 393+26)].						
FS Date: 5/15/2014

Pipe and headwall at LS toe.

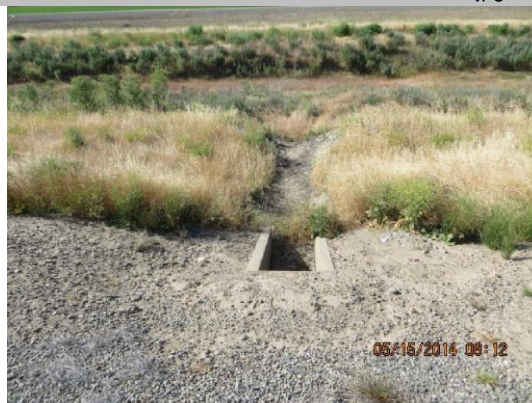
Photo 2 of 3 : UCIP\_FA\_2018\_37840\_68837.jpg

Pipe, headwall, flapgate, and grouted spillway on WS toe.

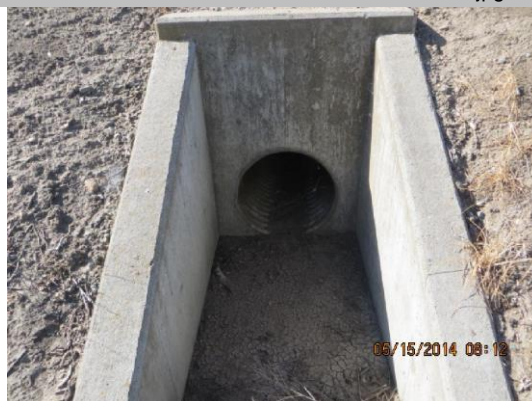
Photo 3 of 3 : UCIP\_FA\_2018\_37840\_68836.jpg

LM Start	7.31	Rating **	A/W	Issue No.	1100 (cont)	
LM End	7.31	Issue Type +	Ma	Location *		
Category	Supplemental			GPS Latitude/Longitude		
				Start	End	
Item	DWR UCIP LMA Responsibility			38.064970 °	38.064970 °	
				-121.251261 °	-121.251261 °	
DWR ID	23564					
Comment Code						
Inspector Comment						
FS_ID:37840 DS_ID:23564 EP_NO: N/A Repair Type: No Action Needed Crossing Status: Found UCIP Comments: FIELD_STRUCT_DESC: 24-inch corrugated metal drainage pipe through the levee, 7.5 feet below the crown. Concrete U-shaped headwalls on both ends. Flap gate on the waterside (WS) end. Cobble grouted spillway across the berm. Cobble grouted apron on the landside (LS) end. [Additional Reference(s): DWR Levee Log, 1987. USACE San Joaquin O&M Manual 612.2, 1967, (HLM 7.72)]. FS Date: 5/15/2014

Pipe and headwall on LS toe.

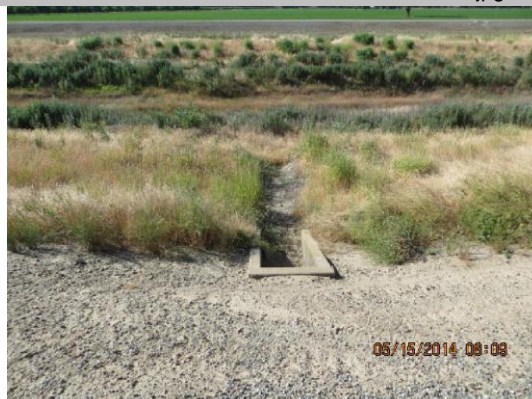
Photo 1 of 3 : UCIP\_FA\_2018\_37839\_68833.jpg

LM Start	7.35	Rating **	A/W	Issue No.	1101	
LM End	7.35	Issue Type +	Ma	Location *		
Category	Supplemental			GPS Latitude/Longitude		
				Start		End
Item	DWR UCIP LMA Responsibility			38.065036 °		38.065036 °
				-121.250691 °		-121.250691 °
DWR ID	23565					
Comment Code						
Inspector Comment						
FS_ID:37839 DS_ID:23565 EP_NO: N/A Repair Type: No Action Needed Crossing Status: Found UCIP Comments: FIELD_STRUCT_DESC: 24-inch corrugated metal drainage pipe through the levee, 7 feet below the crown. Concrete U-shaped headwalls on both ends. Flap gate on the waterside (WS) end. Cobble grouted spillway across the berm. Cobble grouted apron on the landside (LS) end. [Additional Reference(s): DWR Levee Log, 1987. USACE San Joaquin O&M Manual 612.2, 1967, (HLM 7.75)]. FS Date: 5/15/2014

Pipe, headwall, flapgate, and grouted spillway on WS toe.

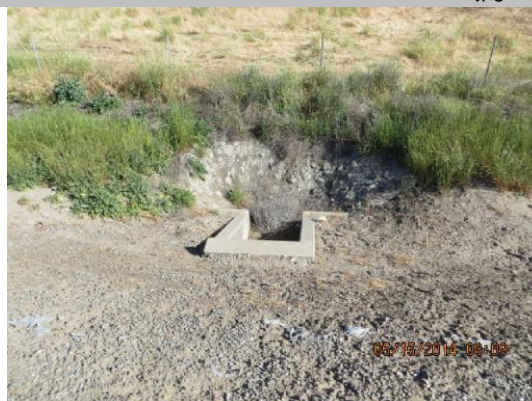
Photo 2 of 3 : UCIP\_FA\_2018\_37839\_68832.jpg

Pipe and headwall on LS toe.

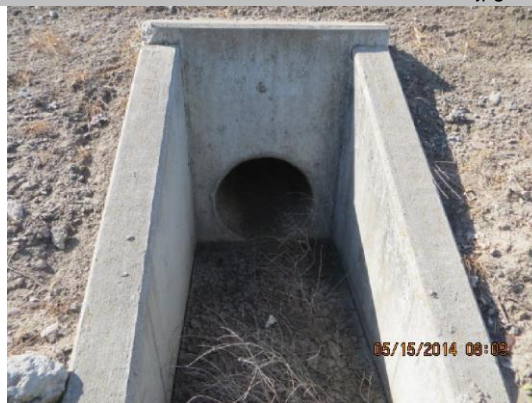
Photo 3 of 3 : UCIP\_FA\_2018\_37839\_68831.jpg

Pipe and headwall on LS toe.

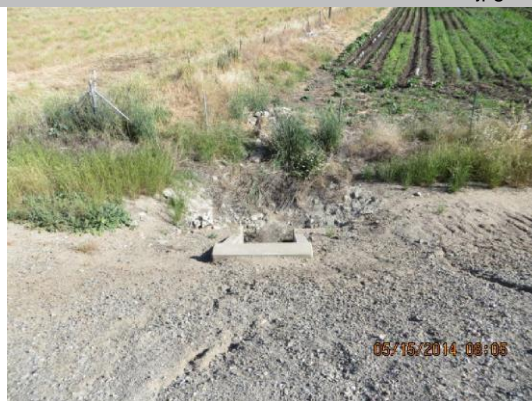
Photo 1 of 3 : UCIP\_FA\_2018\_37838\_68828.jpg

Comment Code						
Inspector Comment						
FS_ID:37838						
DS_ID:23566						
EP_NO: N/A						
Repair Type: No Action Needed						
Crossing Status: Found						
UCIP Comments:						
FIELD_STRUCT_DESC: 24-inch corrugated metal storm drainage pipe through the levee, 7 feet below the crown. Concrete U-shaped headwalls on both ends. Flap gate on the waterside (WS) end. Cobble grouted spillway across the berm. Cobble grouted apron on the landside (LS) end. [Additional Reference(s): DWR Levee Log, 1987. USACE San Joaquin O&M Manual 612.2, 1967, (HLM 7.76) and 612 (addendum), February 1999, (HLM 7.78) (Station 410+54)].						
FS Date: 5/15/2014

Pipe and headwall on LS toe.

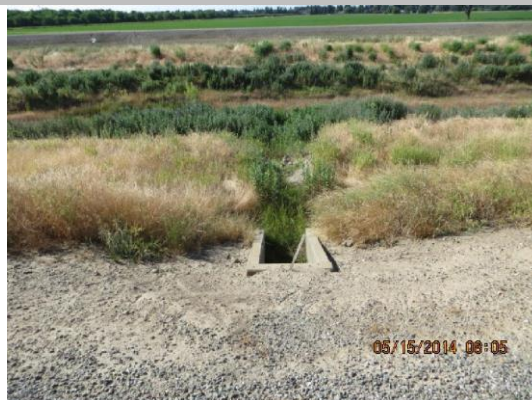
Photo 2 of 3 : UCIP\_FA\_2018\_37838\_68827.jpg

Pipe, headwall, flapgate, and grouted spillway on WS toe.

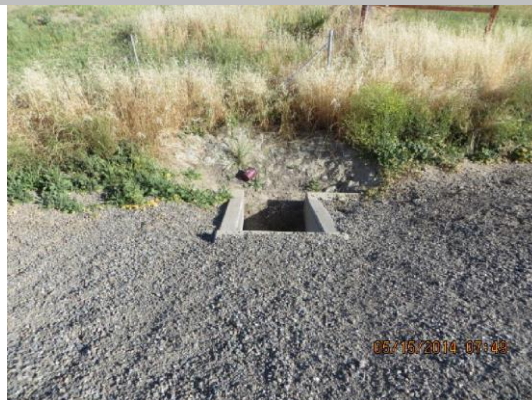
Photo 2 of 3 : UCIP\_FA\_2018\_37837\_68822.jpg

Pipe and headwall on LS toe.

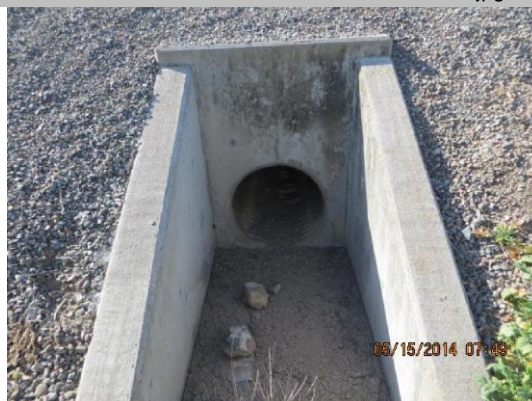
Photo 3 of 3 : UCIP\_FA\_2018\_37837\_68821.jpg

Pipe and headwall on LS toe.

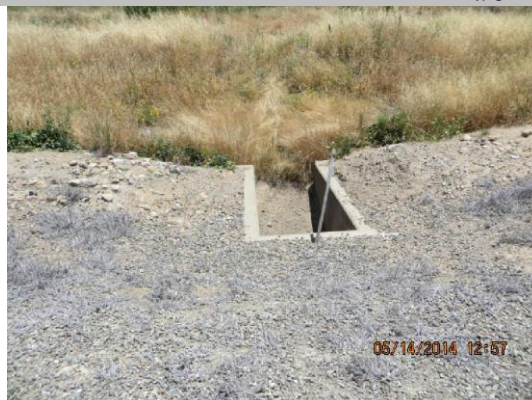
Photo 1 of 3 : UCIP\_FA\_2018\_37835\_68818.jpg

LM Start	7.73	Rating **	A/W	Issue No.	1104	
LM End	7.73	Issue Type +	Ma	Location *		
Category	Supplemental			GPS Latitude/Longitude		
				Start		End
Item	DWR UCIP LMA Responsibility			38.067466 °		38.067466 °
				-121.244455 °		-121.244455 °
DWR ID	23568					
Comment Code						
Inspector Comment						
FS_ID:37835 DS_ID:23568 EP_NO: N/A Repair Type: No Action Needed Crossing Status: Found UCIP Comments: FIELD_STRUCT_DESC: 36-inch corrugated metal drainage pipe through the levee, 8 feet below the crown. Concrete U-shaped headwalls on both ends. Flap gate on the waterside (WS) end. Cobble grouted spillway across the berm. Cobble grouted apron on the landside (LS) end. [Additional Reference(s): DWR Levee Log, 1987. USACE San Joaquin O&M Manual 612.2, 1967, (HLM 8.15)]. FS Date: 5/14/2014

Pipe, flapgate, and headwall at WS toe.

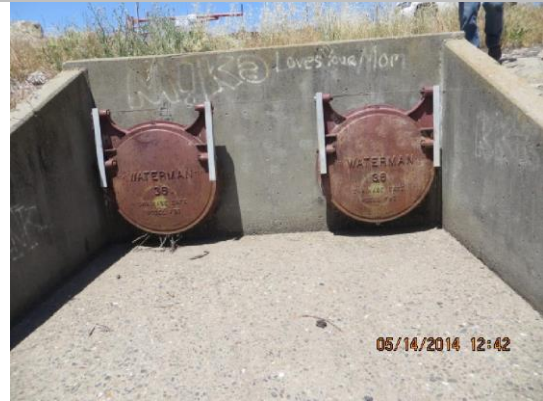
Photo 3 of 3 : UCIP\_FA\_2018\_37832\_68811.jpg

Pipe, headwall, and flapgate on WS toe.

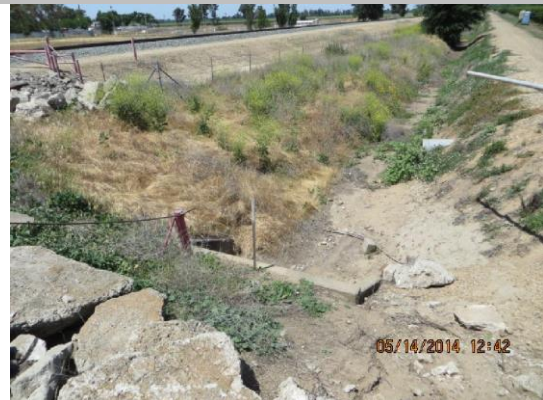
Photo 1 of 3 : UCIP\_FA\_2018\_37831\_68808.jpg

LM Start	7.86	Rating **	A/W	Issue No.	1106
LM End	7.86	Issue Type +	Ma	Location *	
Category	Supplemental			GPS Latitude/Longitude	
				Start	End
Item	DWR UCIP LMA Responsibility			38.067469 °	38.067469 °
				-121.242214 °	-121.242214 °
DWR ID	23682				
Comment Code					
Inspector Comment					
FS_ID:37831 DS_ID:23682 EP_NO: N/A Repair Type: No Action Needed Crossing Status: Found UCIP Comments: FIELD_STRUCT_DESC: 2 of 2: 36-inch corrugated metal drainage pipe through the levee, 10.5 feet below the crown. Flap gate on the waterside (WS) end. Slide gate in 48-inch corrugated metal riser unit on the WS slope. Concrete U-shaped headwall on both ends. Cobble grouted spillway on bank. Cobble grouted apron on the landside (LS) end. [Additional Reference(s): DWR Levee Log, 1987. USACE San Joaquin O&M Manual 612.2, 1967, (HLM 8.28)]. FS Date: 5/14/2014

Pipe and headwall on LS toe.

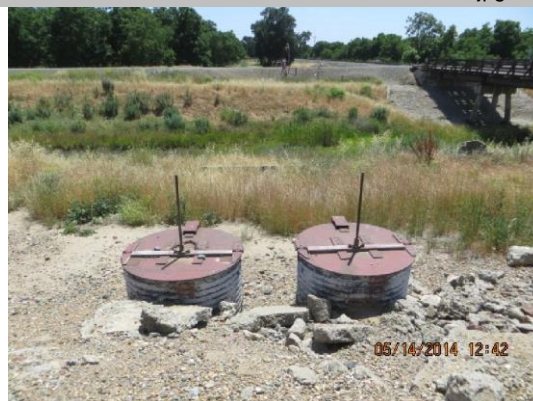
Photo 2 of 3 : UCIP\_FA\_2018\_37831\_68807.jpg

Slide gate in 48-inch CMP riser on WS slope.

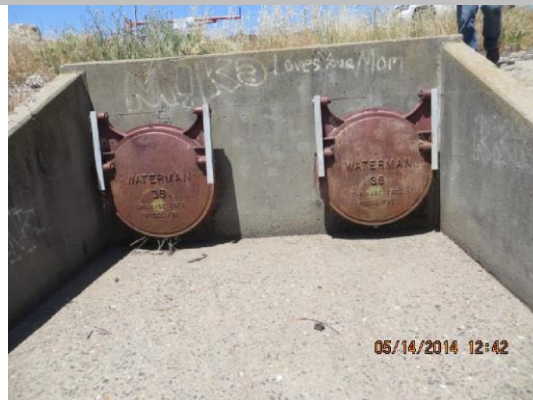
Photo 3 of 3 : UCIP\_FA\_2018\_37831\_68806.jpg

Pipe, flapgate, and headwall on WS slope.
