**Flood Control Project Maintenance  
Levee Inspections**

**Maintenance Issue Types Only, Levee Inspection Report By Mile - Fall 2018**

**San Joaquin County Flood Control and Water Conservation District**

Waterway	Bank	Unit Miles	Inspection Start/End	Inspector
Unit No. 01 Littlejohn Creek	Left	2.59	10/18/2018 10/18/2018	Wade Wylie

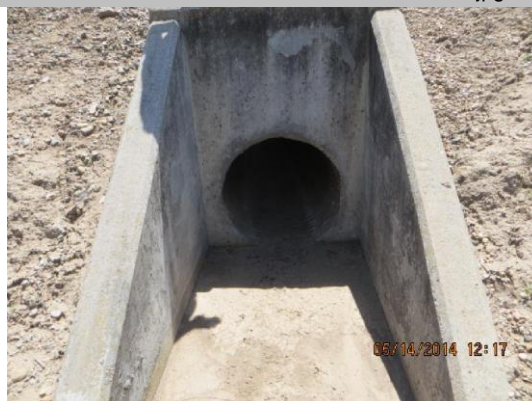
Photo 1 of 3 : UCIP\_FA\_2018\_37826\_68796.jpg

Pipe and headwall on LS toe.

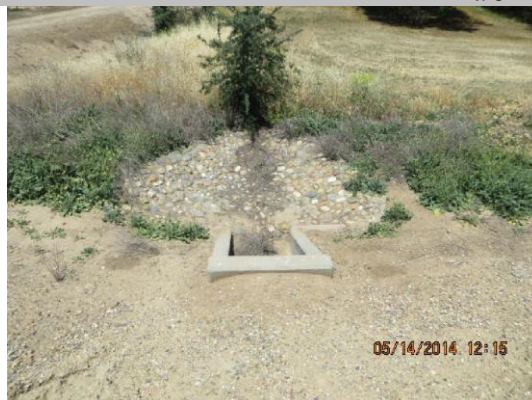
Photo 1 of 3 : UCIP\_FA\_2018\_37825\_68791.jpg

Comment Code					
Inspector Comment					
FS_ID:37825					
DS_ID:23573					
EP_NO: N/A					
Repair Type: Non-Urgent					
Crossing Status: Found					
UCIP Comments: Some gaps in Joints between pipe sections noted inside pipe on LS toe. May indicate a need for further maintenance.					
FIELD_STRUCT_DESC: 24-inch corrugated metal drainage pipe through the levee, 6.5 feet below the crown. Flap gate on the waterside (WS) end. Concrete U-shaped headwalls on both ends. Cobble grouted spillway across the berm. Cobble grouted apron on the landside (LS) end. [Additional Reference(s): DWR Levee Log, 1987. USACE San Joaquin O&M Manual 612.2, 1967, (HLM 8.78)].					
FS Date: 5/14/2014

Pipe and headwall on LS toe.

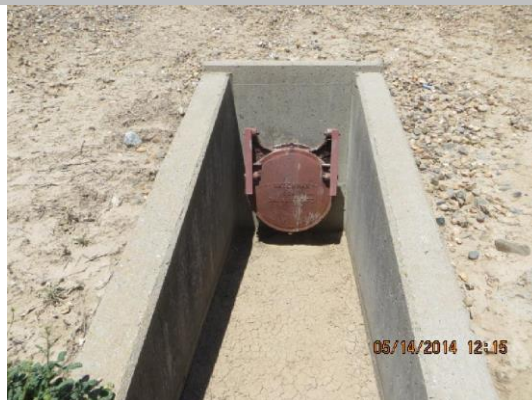
Photo 3 of 3 : UCIP\_FA\_2018\_37825\_68789.jpg

Comment Code						
Inspector Comment						
FS_ID:37825						
DS_ID:23573						
EP_NO: N/A						
Repair Type: Non-Urgent						
Crossing Status: Found						
UCIP Comments: Some gaps in Joints between pipe sections noted inside pipe on LS toe. May indicate a need for further maintenance.						
FIELD_STRUCT_DESC: 24-inch corrugated metal drainage pipe through the levee, 6.5 feet below the crown. Flap gate on the waterside (WS) end. Concrete U-shaped headwalls on both ends. Cobble grouted spillway across the berm. Cobble grouted apron on the landside (LS) end. [Additional Reference(s): DWR Levee Log, 1987. USACE San Joaquin O&M Manual 612.2, 1967, (HLM 8.78)].						
FS Date: 5/14/2014

Pipe, headwall, and flapgate on WS toe.

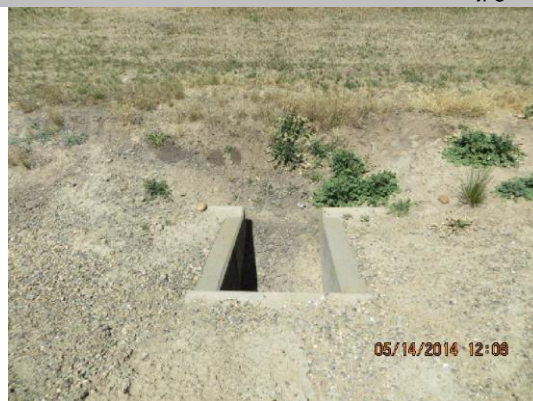
Photo 1 of 3 : UCIP\_FA\_2018\_37818\_68761.jpg

Pipe and headwall on LS toe.

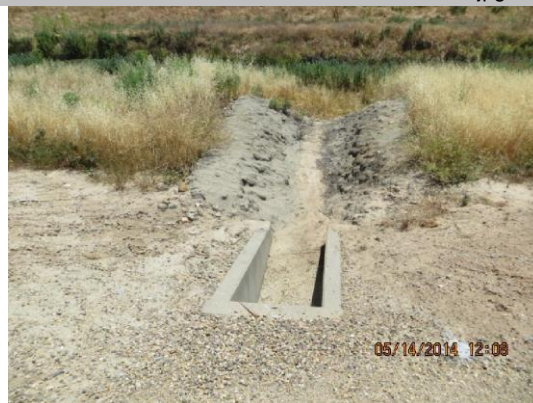
Photo 2 of 3 : UCIP\_FA\_2018\_37818\_68760.jpg

Pipe, flapgate, headwall, and grouted spillway on WS toe.

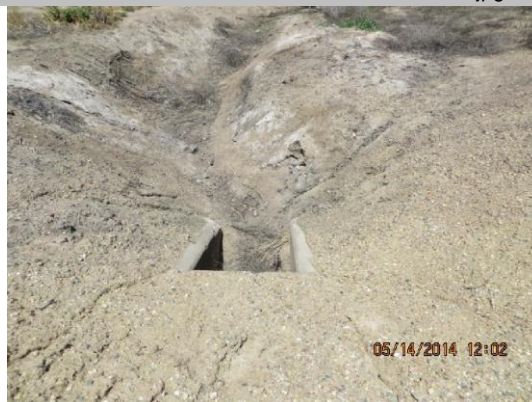
Photo 1 of 3 : UCIP\_FA\_2018\_40206\_68756.jpg

Comment Code						
Inspector Comment						
FS_ID:40206						
DS_ID:23576						
EP_NO: N/A						
Repair Type: No Action Needed						
Crossing Status: Found						
UCIP Comments: Skunks in pipe.						
FIELD_STRUCT_DESC: 24-inch corrugated metal storm drainage pipe through the levee, 6.5 feet below the crown. Flap gate on the waterside (WS) end. Concrete U-shaped headwalls on both ends. Cobble grouted spillway across the berm. Cobble grouted apron on the landside (LS) end. [Additional Reference(s): DWR Levee Log, 1987. USACE San Joaquin O&M Manual 612.2, 1967, (HLM 9.17) and 612 (addendum), February 1999, (HLM 9.17) (Station 484+30)].						
FS Date: 5/14/2014

Pipe and headwall on LS toe.

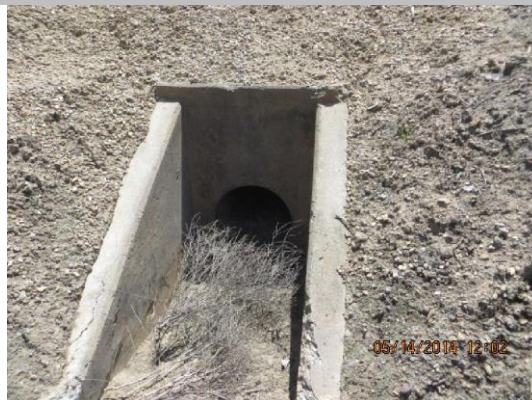
Photo 3 of 3 : UCIP\_FA\_2018\_40206\_68754.jpg

Pipe and headwall on LS toe.

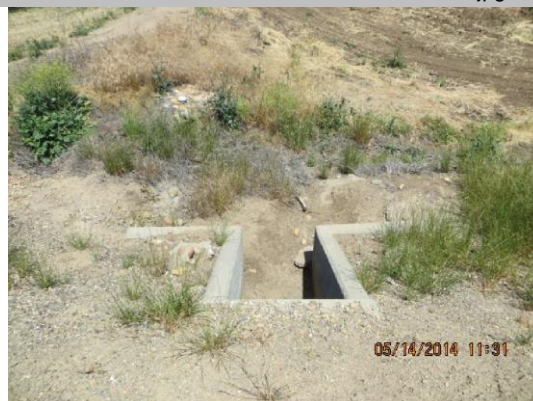
Photo 1 of 3 : UCIP\_FA\_2018\_42951\_68751.jpg

Pipe and headwall on LS toe.

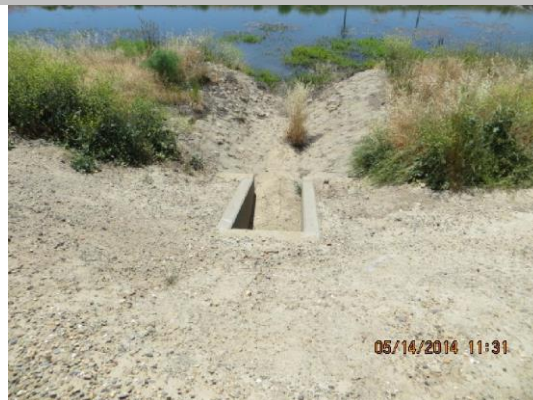
Photo 2 of 3 : UCIP\_FA\_2018\_42951\_68750.jpg

Headwall, pipe, flapgate, and grouted spillway on WS toe.

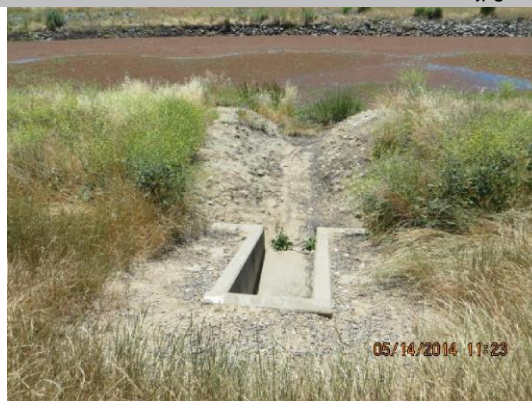
Photo 2 of 3 : UCIP\_FA\_2018\_37813\_68746.jpg

Headwall, pipe, flapgate, and grouted spillway on WS toe.

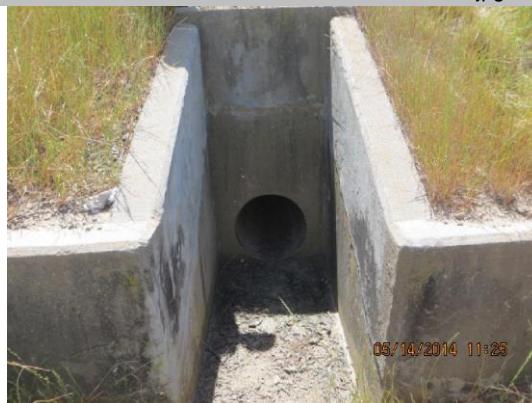
Photo 3 of 3 : UCIP\_FA\_2018\_37813\_68745.jpg

Headwall and pipe at LS toe.

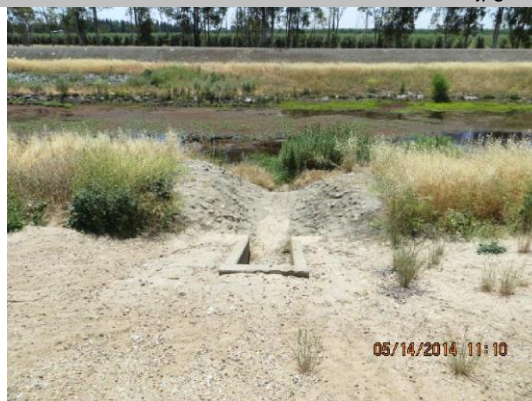
Photo 1 of 3 : UCIP\_FA\_2018\_37810\_68742.jpg

Headwall and flapgate on WS toe.

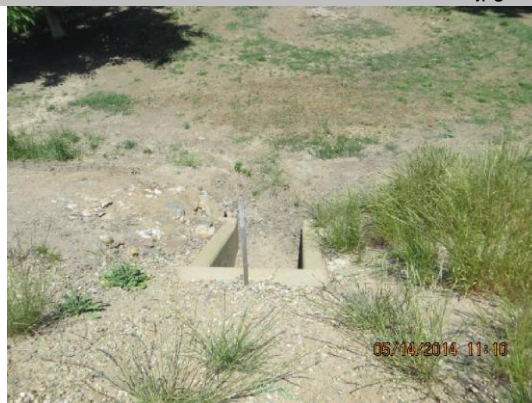
Photo 2 of 3 : UCIP\_FA\_2018\_37810\_68741.jpg

Pipe and headwall on LS toe.

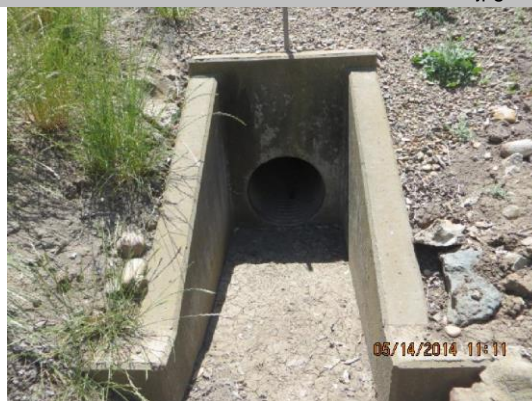
Photo 3 of 3 : UCIP\_FA\_2018\_37810\_68740.jpg

Pipe and headwall on LS toe.

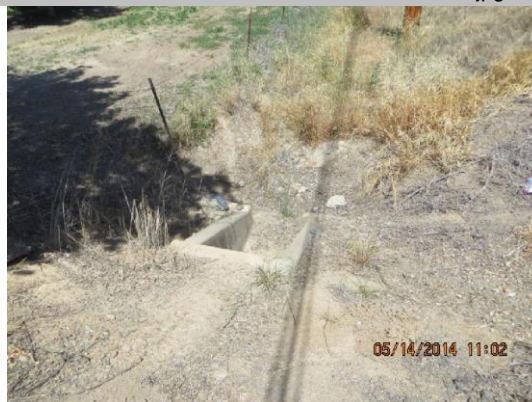
Photo 1 of 3 : UCIP\_FA\_2018\_37809\_68738.jpg

Concrete headwall and pipe on LS toe.

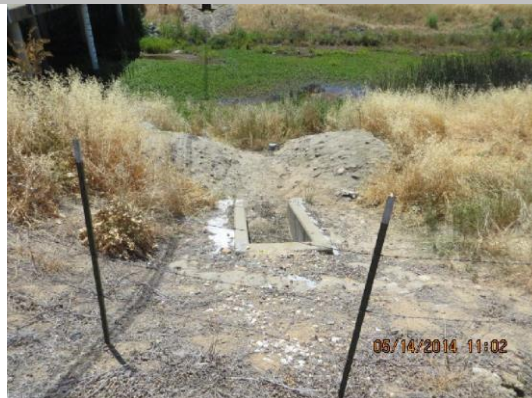
Photo 2 of 3 : UCIP\_FA\_2018\_37809\_68737.jpg

Headwall, pipe, and flapgate on WS toe.

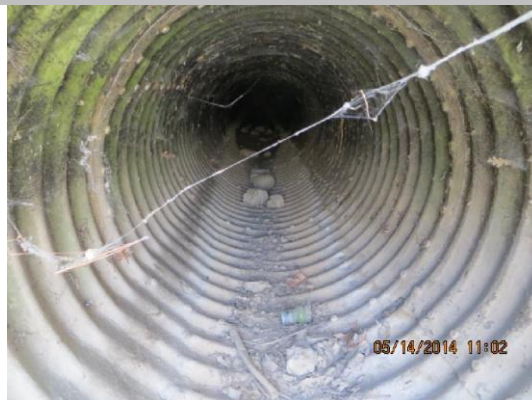
Photo 3 of 3 : UCIP\_FA\_2018\_37809\_68736.jpg

Inside pipe at LS toe.

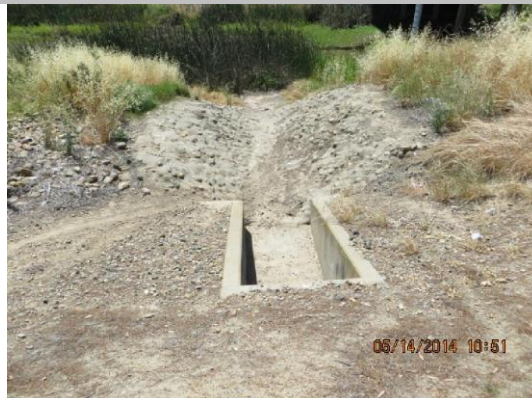
Photo 1 of 3 : UCIP\_FA\_2018\_37807\_68732.jpg

Headwall, pipe, flapgate, and grouted spillway on WS toe.

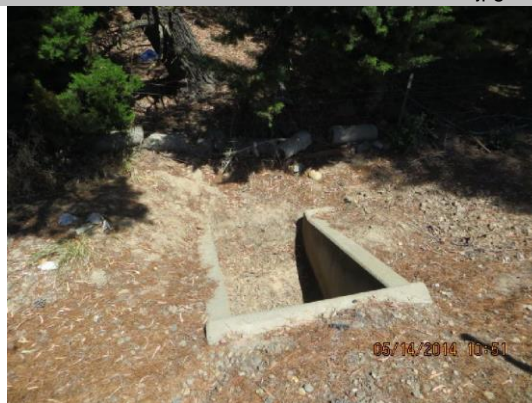
Photo 2 of 3 : UCIP\_FA\_2018\_37807\_68731.jpg

Pipe and headwall on LS toe.

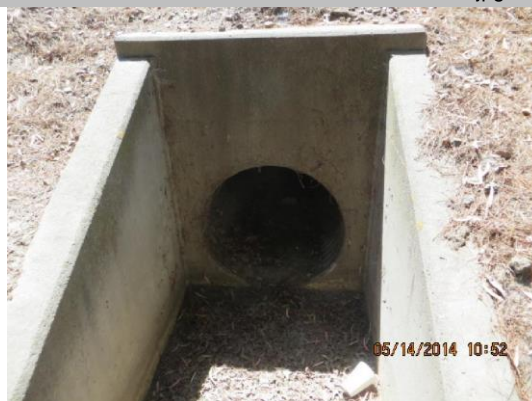
Photo 3 of 3 : UCIP\_FA\_2018\_37807\_68730.jpg

Pipe and headwall on LS toe.

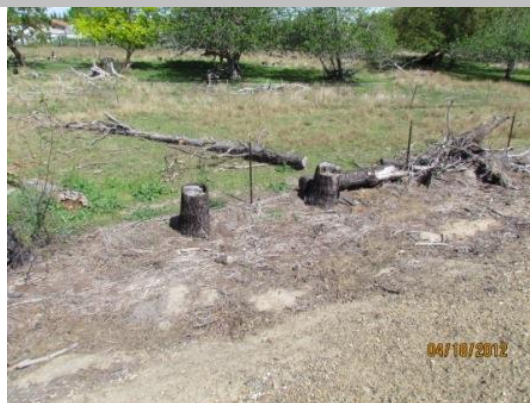
Photo 1 of 1 : FA\_2018\_NA0017\_151\_46\_20180926\_00014.jpg

LM Start	9.76	Rating **	N	Issue No.	46
LM End	9.76	Issue Type +	Ma	Location *	LS
Category	Earthen Levee			GPS Latitude/Longitude	
				Start	End
Item	Trim / Thin Trees			38.074613 °	38.074613 °
				-121.209882 °	-121.209882 °
DWR ID	DWR_NA0017_07_s _ 2012_46				
Comment Code					
T5 : Tree stumps.					
Inspector Comment

View of tree stumps found on the landside of the levee looking upstream.

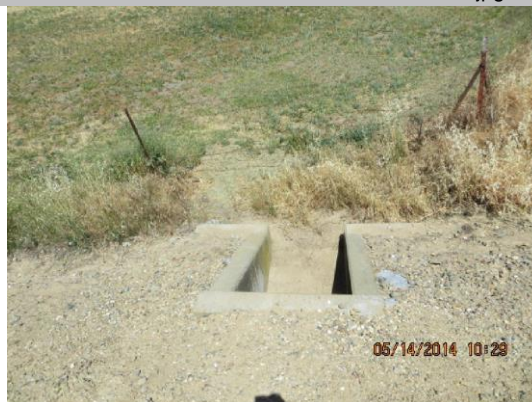
Photo 1 of 3 : UCIP\_FA\_2018\_37803\_68722.jpg

LM Start	10.15	Rating **	A/W	Issue No.	1118	
LM End	10.15	Issue Type +	Ma	Location *		
Category	Supplemental			GPS Latitude/Longitude		
				Start		End
Item	DWR UCIP LMA Responsibility			38.078814 °		38.078814 °
				-121.205762 °		-121.205762 °
DWR ID	23586					
Comment Code						
Inspector Comment						
FS_ID:37803 DS_ID:23586 EP_NO: N/A Repair Type: No Action Needed Crossing Status: Found UCIP Comments: FIELD_STRUCT_DESC: 24-inch corrugated metal drainage pipe through the levee, 6 feet below the crown. Flap gate on the waterside (WS) end. Concrete U-shaped headwalls on both ends. Cobble grouted spillway across the berm. Cobble grouted apron on the landside (LS) end. [Additional Reference(s): USACE San Joaquin O&M Manual 612.2, 1967, (HLM 10.62)]. FS Date: 5/14/2014

Pipe and headwall on LS toe.

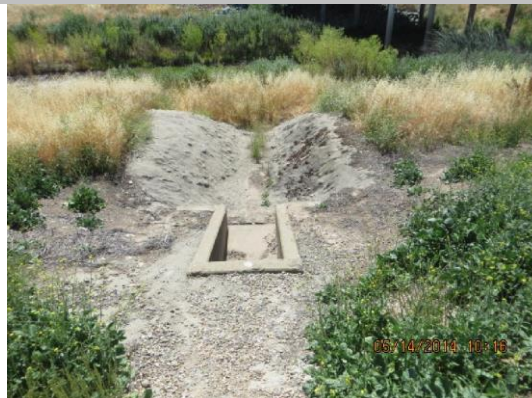
Photo 1 of 3 : UCIP\_FA\_2018\_37786\_68701.jpg

LM Start	10.43	Rating **	A/W	Issue No.	1119
LM End	10.43	Issue Type +	Ma	Location *	
Category	Supplemental			GPS Latitude/Longitude	
				Start	End
Item	DWR UCIP LMA Responsibility			38.080050 °	38.080050 °
				-121.201087 °	-121.201087 °
DWR ID	23646				
Comment Code					
Inspector Comment					
FS_ID:37786 DS_ID:23646 EP_NO: N/A Repair Type: No Action Needed Crossing Status: Found UCIP Comments: FIELD_STRUCT_DESC: 24-inch corrugated metal storm drainage pipe through the levee, 7.5 feet below the crown. Flap gate on the waterside (WS). Concrete U-shaped headwall on both ends. [Additional Reference(s): DWR Levee Log, 1987. USACE San Joaquin O&M Manual 612.2, 1967, (HLM 10.91) and 612 (addendum), February 1999, (HLM 10.80) (Station 570+48)]. FS Date: 5/14/2014

Pipe, headwall, flapgate, and grouted spillway on WS slope.

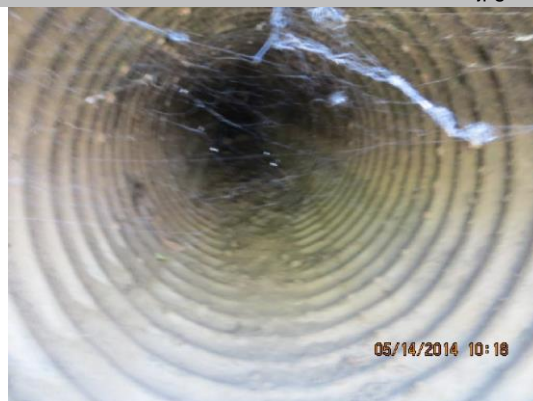
Photo 3 of 3 : UCIP\_FA\_2018\_37786\_68703.jpg

Inside pipe from LS toe.

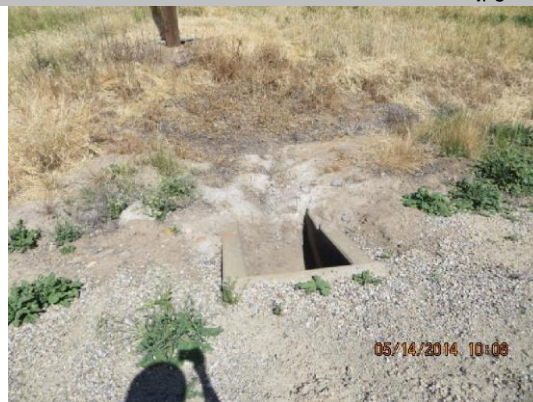
Photo 1 of 3 : UCIP\_FA\_2018\_41805\_68682.jpg

LM Start	10.65	Rating **	M	Issue No.	1120	
LM End	10.65	Issue Type +	Ma	Location *		
Category	Supplemental			GPS Latitude/Longitude		
				Start		End
Item	DWR UCIP LMA Responsibility			38.082589 °		38.082589 °
				-121.198521 °		-121.198521 °
DWR ID	23587					
Comment Code						
Inspector Comment						
FS_ID:41805 DS_ID:23587 EP_NO: N/A Repair Type: Non-Urgent Crossing Status: Found UCIP Comments: Silt buildup in pipe at LS toe. FIELD_STRUCT_DESC: 24-inch corrugated metal drainage pipe through the levee, 6.5 feet below the crown. Flap gate on the waterside (WS) end. Concrete U-shaped headwall on both ends. Cobble grouted spillway across the berm. Cobble grouted apron on the WS end. [Additional Reference(s): DWR Levee Log, 1987. USACE San Joaquin O&M Manual 612.2, 1967, (HLM 11.13)]. FS Date: 5/14/2014

Pipe and headwall on LS toe.

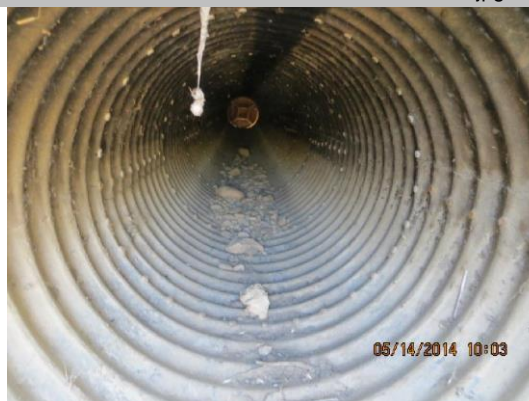
Photo 3 of 3 : UCIP\_FA\_2018\_37779\_68659.jpg

Inside pipe at LS toe.

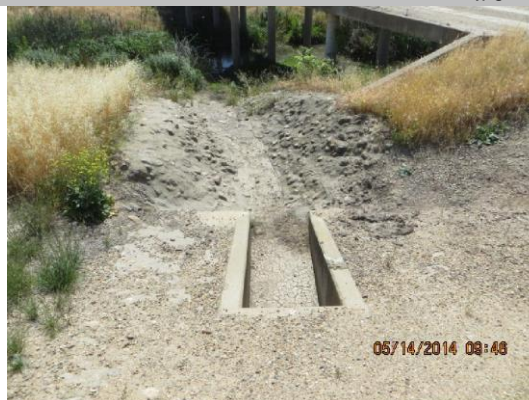
Photo 1 of 3 : UCIP\_FA\_2018\_37773\_68635.jpg

LM Start	11.27	Rating **	A/W	Issue No.	1122	
LM End	11.27	Issue Type +	Ma	Location *		
Category	Supplemental			GPS Latitude/Longitude		
				Start		End
Item	DWR UCIP LMA Responsibility			38.087249 °		38.087249 °
				-121.189337 °		-121.189337 °
DWR ID	23590					
Comment Code						
Inspector Comment						
FS_ID:37773						
DS_ID:23590						
EP_NO: N/A						
Repair Type: No Action Needed						
Crossing Status: Found						
UCIP Comments:						
FIELD_STRUCT_DESC: 24-inch corrugated metal drainage pipe through the levee, 7.5 feet below the crown. Flap gate on the waterside (WS) end. Concrete U-shaped headwalls on both ends. Cobble grouted spillway across the berm. Cobble grouted apron on the landside (LS) end. [Additional Reference(s): DWR Levee Log, 1987. USACE San Joaquin O&M Manual 612.2, 1967, (HLM 11.78)].						
FS Date: 5/14/2014

Headwall, pipe, flapgate, and grouted spillway on WS slope.

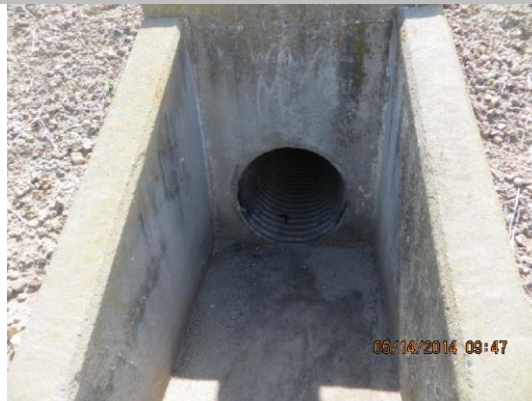
Photo 3 of 3 : UCIP\_FA\_2018\_37773\_68633.jpg

Pipe and headwall on LS toe.

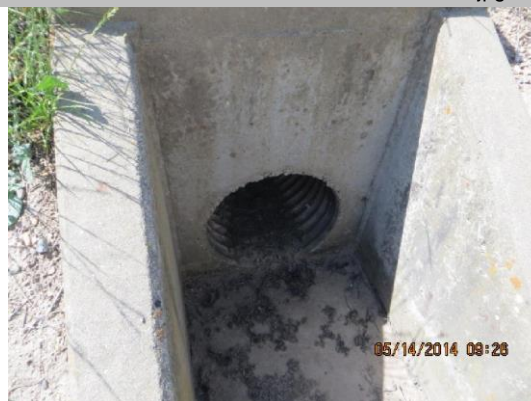
Photo 3 of 3 : UCIP\_FA\_2018\_37753\_68592.jpg

Pipe and headwall on LS toe.

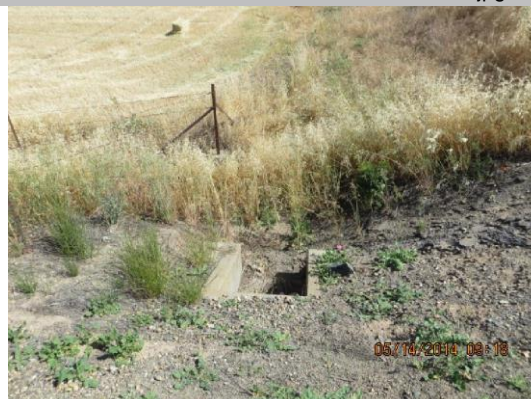
Photo 1 of 3 : UCIP\_FA\_2018\_53044\_68589.jpg

Comment Code					
Inspector Comment					
FS_ID:53044 DS_ID:23594 EP_NO: N/A Repair Type: No Action Needed Crossing Status: Found UCIP Comments: 10/10/2018 20-inch Snap-Tite lining pipes were sleeved through the damaged 24-inch CMP culvert. Annular space was pressure grouted. FIELD_STRUCT_DESC: 24-inch corrugated metal drainage culvert through the levee, 7.5 feet below the crown. 20-inch Snap-Tite lining pipes sleeved through the 24-inch corrugated metal drainage culvert, 10/09/2018. Annular space pressure grouted, 10/10/2018. Flap gate on the waterside (WS) end. Concrete U-shaped headwall on each end. Cobble grouted spillway across berm. Cobble grouted apron on the landside (LS) end. [Additional Reference(s): DWR Levee Log, 1987. USACE San Joaquin O&M Manual 612.2, 1967, (HLM 12.40)]. FS Date: 10/10/2018

Pipe and headwall at the LS toe.

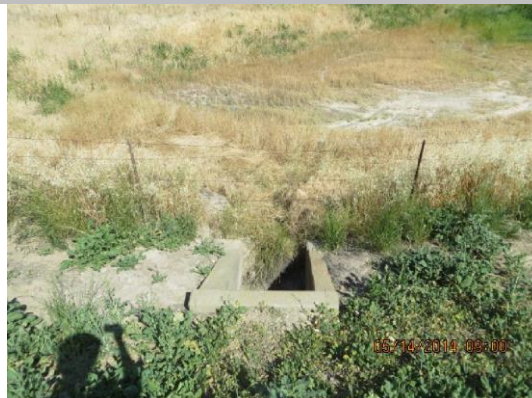
Photo 2 of 3 : UCIP\_FA\_2018\_37745\_68566.jpg

Pipe and headwall on LS toe.

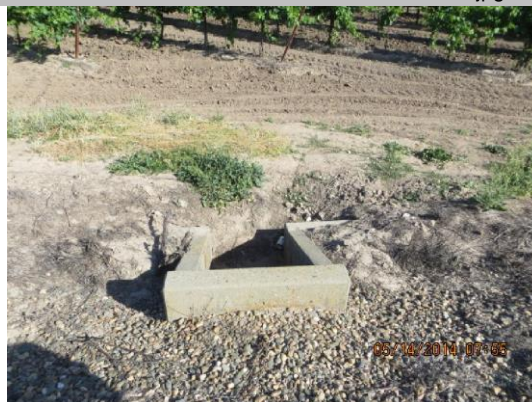
Photo 1 of 3 : UCIP\_FA\_2018\_37690\_68450.jpg

LM Start	13.09	Rating **	A/W	Issue No.	1137	
LM End	13.09	Issue Type +	Ma	Location *		
Category	Supplemental			GPS Latitude/Longitude		
				Start		End
Item	DWR UCIP LMA Responsibility			38.106393 °		38.106393 °
				-121.175587 °		-121.175587 °
DWR ID	23597					
Comment Code						
Inspector Comment						
FS_ID:37690 DS_ID:23597 EP_NO: N/A Repair Type: No Action Needed Crossing Status: Found UCIP Comments: FIELD_STRUCT_DESC: 24-inch corrugated metal drainage pipe through the levee, 5.5 feet below the crown. Concrete U-shaped headwall on both ends. Flap gate on the waterside (WS) slope. Cobble grouted spillway. Cobble grouted intake on the landside (LS). [Additional Reference(s): DWR Levee Log, 1987. USACE San Joaquin O&M Manual 612.2, 1967, (HLM 13.64)]. FS Date: 5/14/2014

Pipe and headwall on LS toe.

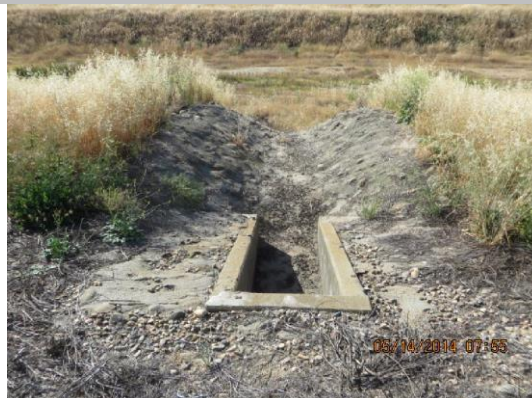
Photo 2 of 3 : UCIP\_FA\_2018\_37690\_68449.jpg

Pipe, flapgate, headwall, and grouted spillway on WS slope.

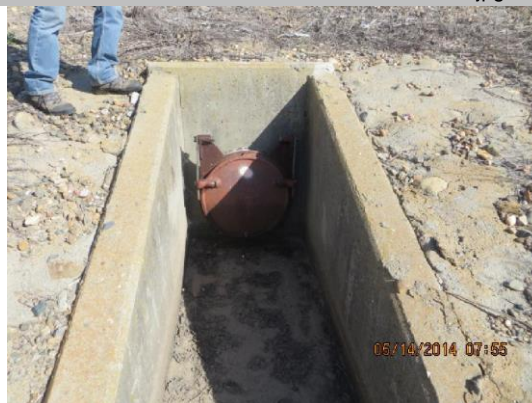
Photo 3 of 3 : UCIP\_FA\_2018\_37690\_68448.jpg

Pipe, flapgate, headwall, and grouted spillway on WS slope.

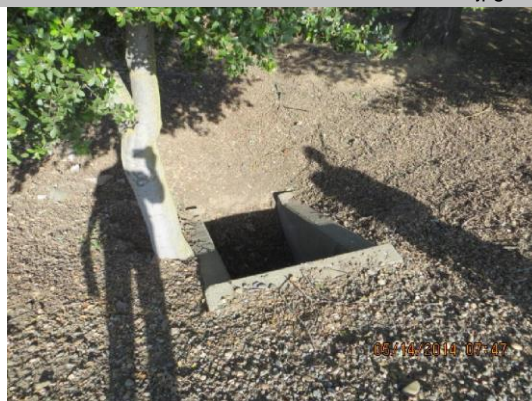
Photo 1 of 3 : UCIP\_FA\_2018\_37689\_68446.jpg

LM Start	13.48	Rating **	A/W	Issue No.	1138
LM End	13.48	Issue Type +	Ma	Location *	
Category	Supplemental			GPS Latitude/Longitude	
				Start	End
Item	DWR UCIP LMA Responsibility			38.111310 °	38.111310 °
				-121.172760 °	-121.172760 °
DWR ID	23598				
Comment Code					
Inspector Comment					
FS_ID:37689 DS_ID:23598 EP_NO: N/A Repair Type: No Action Needed Crossing Status: Found UCIP Comments: FIELD_STRUCT_DESC: 24-inch corrugated metal drainage pipe through the levee, 7.5 feet below the crown. Concrete U-shaped headwall on both ends. Flap gate on the waterside (WS) end. Cobble grouted spillway. Cobble grouted intake on the landside (LS) slope. [Additional Reference(s): DWR Levee Log, 1987. USACE San Joaquin O&M Manual 612.2, 1967, (HLM 14.04)]. FS Date: 5/14/2014

Pipe and concrete headwall on LS slope.

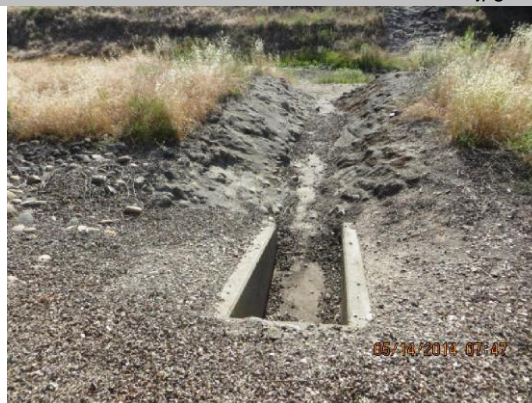
Photo 2 of 3 : UCIP\_FA\_2018\_37689\_68445.jpg

Pipe, flapgate, headwall, and grouted spillway on WS slope.

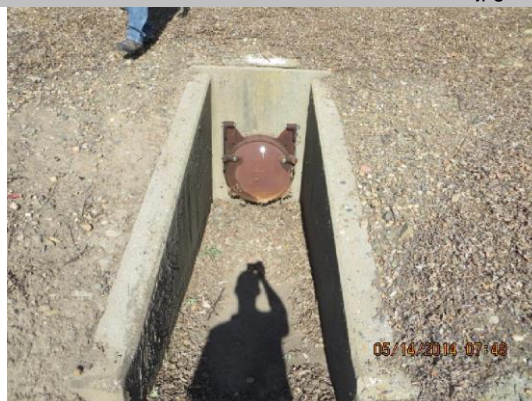
Photo 3 of 3 : UCIP\_FA\_2018\_37689\_68444.jpg

LM Start	13.48	Rating **	A/W	Issue No.	1138 (cont)
LM End	13.48	Issue Type +	Ma	Location *	
Category	Supplemental			GPS Latitude/Longitude	
				Start	End
Item	DWR UCIP LMA Responsibility			38.111310 °	38.111310 °
				-121.172760 °	-121.172760 °
DWR ID	23598				
Comment Code					
Inspector Comment					
FS_ID:37689 DS_ID:23598 EP_NO: N/A Repair Type: No Action Needed Crossing Status: Found UCIP Comments: FIELD_STRUCT_DESC: 24-inch corrugated metal drainage pipe through the levee, 7.5 feet below the crown. Concrete U-shaped headwall on both ends. Flap gate on the waterside (WS) end. Cobble grouted spillway. Cobble grouted intake on the landside (LS) slope. [Additional Reference(s): DWR Levee Log, 1987. USACE San Joaquin O&M Manual 612.2, 1967, (HLM 14.04)]. FS Date: 5/14/2014

Pipe, flapgate, headwall, and grouted spillway on WS slope.

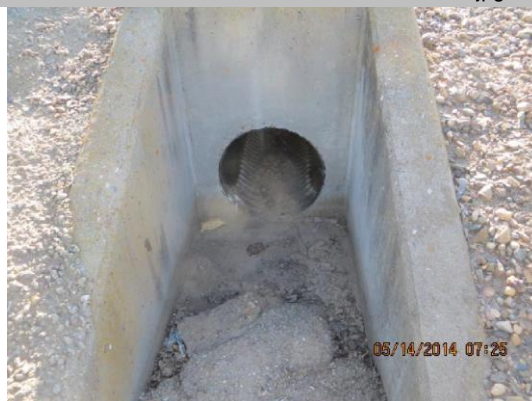
Photo 3 of 3 : UCIP\_FA\_2018\_37675\_68402.jpg

LM Start	13.82	Rating **	A/W	Issue No.	1140 (cont)
LM End	13.82	Issue Type +	Ma	Location *	
Category	Supplemental			GPS Latitude/Longitude	
				Start	End
Item	DWR UCIP LMA Responsibility			38.116150 °	38.116150 °
				-121.172220 °	-121.172220 °
DWR ID	23600				
Comment Code					
Inspector Comment					
FS_ID:37675					
DS_ID:23600					
EP_NO: N/A					
Repair Type: No Action Needed					
Crossing Status: Found					
UCIP Comments:					
FIELD_STRUCT_DESC: 24-inch corrugated metal drainage pipe through the levee, 6 feet below the crown. Concrete U-shaped headwall on both ends. Flap gate on the waterside (WS) end. Cobble grouted spillway. [Additional Reference(s): DWR Levee Log, 1987. USACE San Joaquin O&M Manual 612.2, 1967, (HLM 14.37)].					
FS Date: 5/14/2014

Pipe and concrete headwall on LS toe.

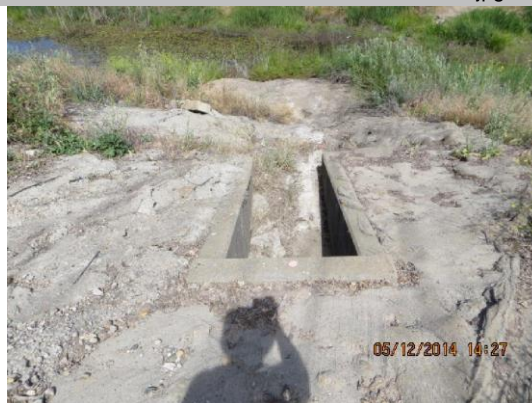
Photo 1 of 3 : UCIP\_FA\_2018\_37666\_68385.jpg

Comment Code					
Inspector Comment					
FS_ID:37666					
DS_ID:23601					
EP_NO: N/A					
Repair Type: No Action Needed					
Crossing Status: Found					
UCIP Comments:					
FIELD_STRUCT_DESC: 24-inch corrugated metal drainage pipe through the levee, 8 feet below the crown. Concrete U-shaped headwall on the waterside (WS) end. Flap gate on the WS end. Cobble grouted spillway. 24-inch corrugated metal drop inlet and cobble grouted intake on the landside (LS), no headwall. (Drainage ditch and 12-inch culverts adjacent to levee installed under Permit No. 12659, 1979 - Richard Stasand). [Additional Reference(s): DWR Levee Log, 1987. USACE San Joaquin O&M Manual 612.2, 1967, (HLM 14.39)].					
FS Date: 5/12/2014

Pipe, flapgate, and headwall on WS slope.

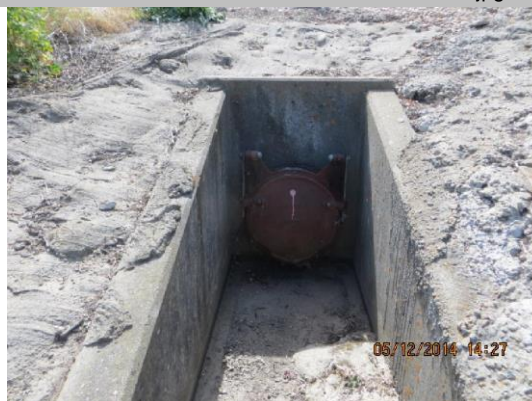
Photo 2 of 3 : UCIP\_FA\_2018\_37666\_68384.jpg

Item	DWR UCIP LMA Responsibility			38.116423	°	38.116423
				-121.172178	°	-121.172178
DWR ID	23601					
Comment Code						
Inspector Comment						
FS_ID:37666						
DS_ID:23601						
EP_NO: N/A						
Repair Type: No Action Needed						
Crossing Status: Found						
UCIP Comments:						
FIELD_STRUCT_DESC: 24-inch corrugated metal drainage pipe through the levee, 8 feet below the crown. Concrete U-shaped headwall on the waterside (WS) end. Flap gate on the WS end. Cobble grouted spillway. 24-inch corrugated metal drop inlet and cobble grouted intake on the landside (LS), no headwall. (Drainage ditch and 12-inch culverts adjacent to levee installed under Permit No. 12659, 1979 - Richard Stasand). [Additional Reference(s): DWR Levee Log, 1987. USACE San Joaquin O&M Manual 612.2, 1967, (HLM 14.39)].						
FS Date: 5/12/2014

Pipe, flapgate, and headwall on WS slope.

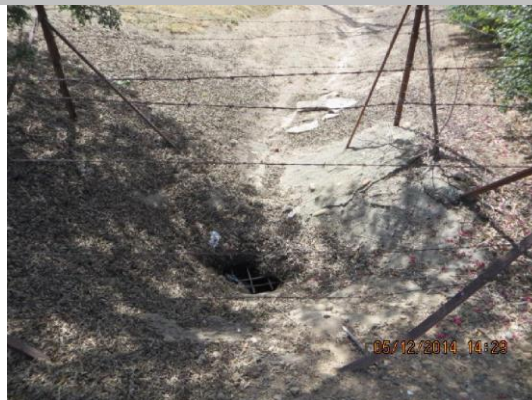
Photo 3 of 3 : UCIP\_FA\_2018\_37666\_68383.jpg

Drop-inlet on LS toe.

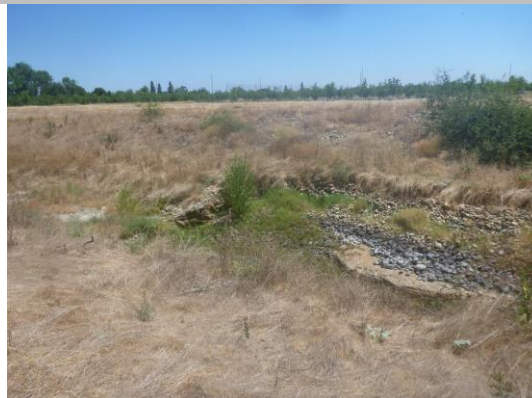
Photo 1 of 3 : LEVAL\_FA\_2018\_478\_2262.jpg

LM Start	14.27	Rating **	A/W	Issue No.	139
LM End	14.27	Issue Type +	Ma	Location *	
Category	Supplemental			GPS Latitude/Longitude	
				Start	End
Item	2017 Storm Damage			38.122152°	38.122152°
				-121.169461°	-121.169461°
DWR ID	DWR_NA0017_07_f_2017_139

Comment Code					
Inspector Comment					
Levee Evaluation Comments					
Description:Erosion on the waterside toe of the levee. The Lat, Long above is from the Spring DWR inspection report, which took the photo and GPS from the right bank. The erosion is on the left bank.					
Site ID No:478					
Site Designation:LMA-305					
Repair Type: Erosion					
Rating:Area of Concern					
Field Date:7/27/2017					
Notes: Levee is small, but there is a fairly large berm. Erosion is present on both banks with 8 ft scarp. There is a big drop in the channel bottom here that could cause eddies and faster erosion. Riprap is just cobble, not clean rock.

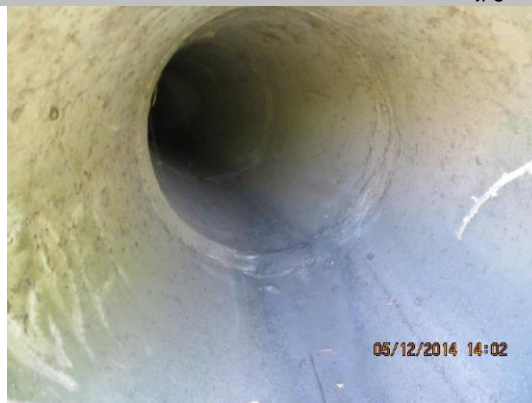
Photo 3 of 3 : UCIP\_FA\_2018\_37660\_68352.jpg

Inside concrete pipe at LS toe.

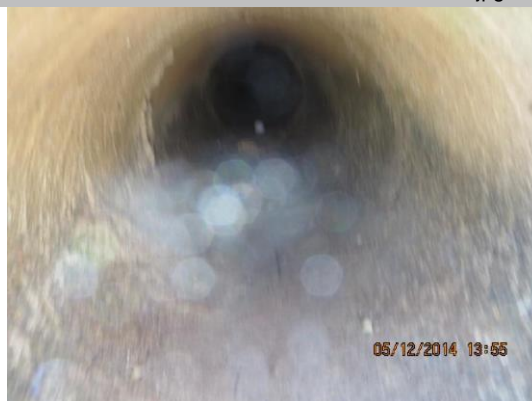
Photo 3 of 3 : UCIP\_FA\_2018\_37658\_68341.jpg

LM Start	14.54	Rating **	A/W	Issue No.	1149 (cont)	
LM End	14.54	Issue Type +	Ma	Location *		
Category	Supplemental			GPS Latitude/Longitude		
				Start	End	
Item	DWR UCIP LMA Responsibility			38.125671 °	38.125671 °	
				-121.167975 °	-121.167975 °	
DWR ID	23605					
Comment Code						
Inspector Comment						
FS_ID:37658						
DS_ID:23605						
EP_NO: N/A						
Repair Type: No Action Needed						
Crossing Status: Found						
UCIP Comments: No flapgate. Pipe not visible on LS.						
FIELD_STRUCT_DESC: 14-inch reinforced concrete drainage pipe through the levee, 4.7 feet below the crown. Cobble grouted spillway. Open on both ends. [Additional Reference(s): DWR Levee Log, 1987, 12-inch pipe listed. USACE San Joaquin O&M Manual 612.2, 1967, (HLM 15.10) 12-inch pipe listed].						
FS Date: 5/12/2014

Inside pipe at WS slope.

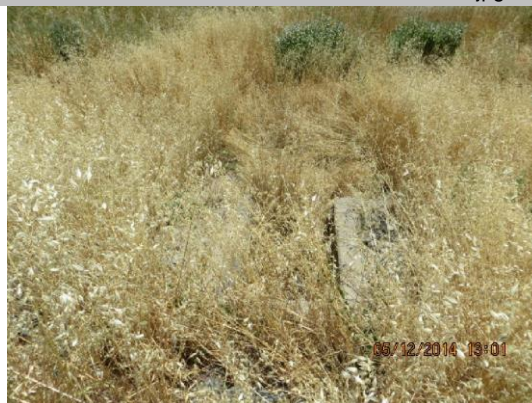
Photo 2 of 3 : UCIP\_FA\_2018\_37652\_68325.jpg

Concrete headwall on WS toe.

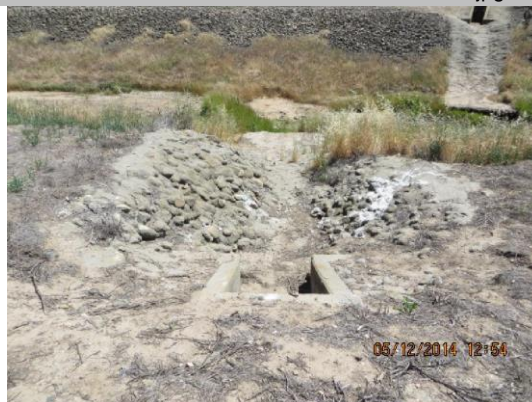
Photo 1 of 3 : UCIP\_FA\_2018\_37651\_68322.jpg

LM Start	15.31	Rating **	A/W	Issue No.	1155	
LM End	15.31	Issue Type +	Ma	Location *		
Category	Supplemental			GPS Latitude/Longitude		
				Start		End
Item	DWR UCIP LMA Responsibility			38.130361 °		38.130361 °
				-121.155686 °		-121.155686 °
DWR ID	23611					
Comment Code						
Inspector Comment						
FS_ID:37651 DS_ID:23611 EP_NO: N/A Repair Type: No Action Needed Crossing Status: Found UCIP Comments: FIELD_STRUCT_DESC: 24-inch corrugated metal drainage pipe through the levee, 4 feet below the crown. Concrete U-shaped headwall on both ends. Flap gate on the waterside (WS) end. Cobble grouted spillway. Cobble grouted intake on the landside (LS). [Additional Reference(s): DWR Levee Log, 1987. USACE San Joaquin O&M Manual 612.2, 1967, (HLM 15.90)]. FS Date: 5/12/2014

Concrete headwall and grouted spillway on WS slope.

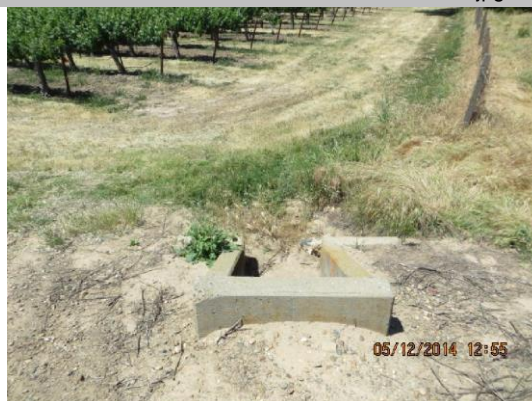
Photo 2 of 3 : UCIP\_FA\_2018\_37651\_68321.jpg

LM Start	15.31	Rating **	A/W	Issue No.	1155 (cont)
LM End	15.31	Issue Type +	Ma	Location *	
Category	Supplemental			GPS Latitude/Longitude	
				Start	End
Item	DWR UCIP LMA Responsibility			38.130361°	38.130361°
				-121.155686°	-121.155686°
DWR ID	23611				
Comment Code					
Inspector Comment					
FS_ID:37651 DS_ID:23611 EP_NO: N/A Repair Type: No Action Needed Crossing Status: Found UCIP Comments: FIELD_STRUCT_DESC: 24-inch corrugated metal drainage pipe through the levee, 4 feet below the crown. Concrete U-shaped headwall on both ends. Flap gate on the waterside (WS) end. Cobble grouted spillway. Cobble grouted intake on the landside (LS). [Additional Reference(s): DWR Levee Log, 1987. USACE San Joaquin O&M Manual 612.2, 1967, (HLM 15.90)]. FS Date: 5/12/2014

concrete headwall on LS toe.

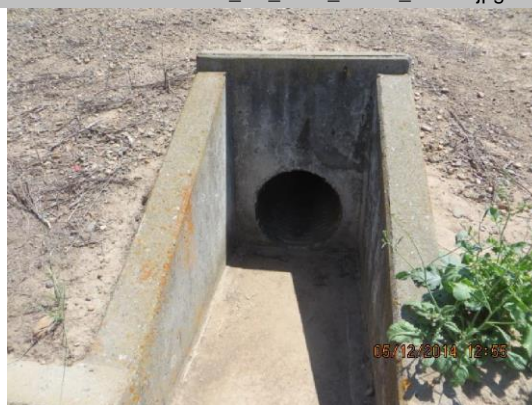
Photo 3 of 3 : UCIP\_FA\_2018\_37651\_68320.jpg

concrete headwall on LS toe.

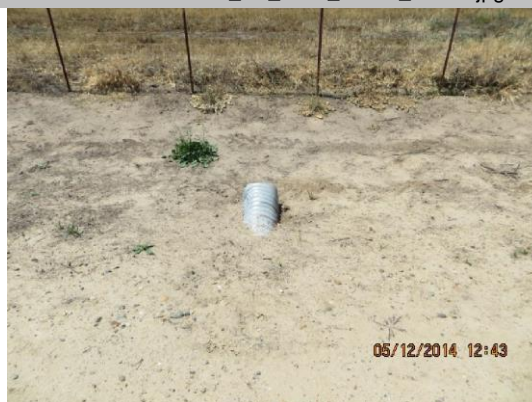
Photo 2 of 3 : UCIP\_FA\_2018\_53498\_68318.jpg

Pipe at inlet on LS toe.

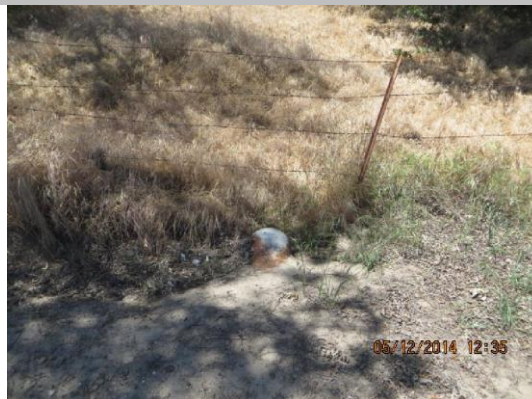
Photo 2 of 3 : UCIP\_FA\_2018\_53499\_68315.jpg

Pipe at inlet on LS shoulder.

Item	DWR UCIP LMA Responsibility			38.135676 °	38.135676 °	
				-121.152769 °	-121.152769 °	
DWR ID	23614					
Comment Code						
Inspector Comment						
FS_ID:53499 DS_ID:23614 EP_NO: N/A Repair Type: Urgent Crossing Status: Found UCIP Comments: 09/18/2018 Levee is so short that it's almost nonexistent. Pipe goes just under levee and acts as an open storm drain. There is a flooding potential because this pipe is open and goes straight through the levee; therefore, this crossing remains "Urgent." (A. McDonald - DWR UCIP)04/20/2017 Pipe is open on both ends. Requires a positive closure device. Crossing has been upgraded from No Action Needed to Urgent. (K. Fazel - UCIP) FIELD_STRUCT_DESC: 12-inch corrugated metal drainage culvert through the levee, 2 feet below the crown. Cobble grouted spillway. Open on both ends. [Additional Reference(s): DWR Levee Log, 1987. USACE San Joaquin O&M Manual 612.2, 1967, (HLM 16.32)]. FS Date: 9/18/2018

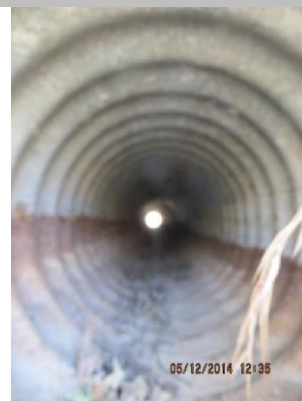
Photo 3 of 3 : UCIP\_FA\_2018\_53499\_68314.jpg

Inside pipe at LS inlet.

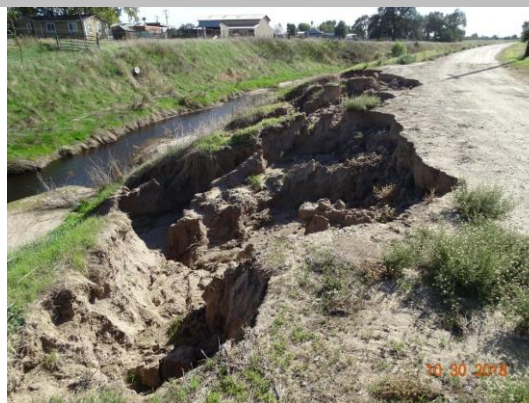
Photo 1 of 2 : FA\_2018\_NA0017\_151\_180\_20181031\_00344.jpg

LM Start	15.88	Rating **	U	Issue No.	180
LM End	15.88	Issue Type +	Ma	Location *	WS
Category	Earthen Levee			GPS Latitude/Longitude	
				Start	End
Item	Erosion / Bank Caving			38.137840 °	38.137840 °
				-121.152028 °	-121.152028 °
DWR ID	DWR_NA0017_07_f_2018_180				
Comment Code					
E2 : Schedule repair of erosion site prior to the next inspection.					
Inspector Comment					
Runoff from previous rain.

View of erosion on the waterside slope. Fall 2018.

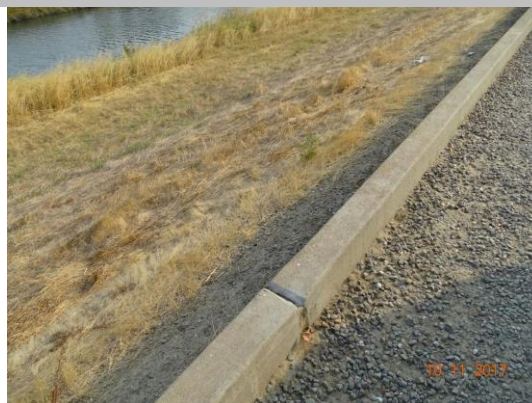
Photo 1 of 1 : FA\_2018\_NA0017\_152\_162\_20180926\_00032.jpg

LM Start	1.43	Rating **	M	Issue No.	162
LM End	1.43	Issue Type +	Ma	Location *	WS
Category	Concrete Floodwalls			GPS Latitude/Longitude	
				Start	End
Item	Monolith Joints			38.042861 °	38.042861 °
				-121.357973 °	-121.357973 °
DWR ID	DWR_NA0017_08_f_2017_162				
Comment Code					
Inspector Comment					
This portion of the floodwall has deteriorated monolith joints.

View of damaged monolith joint on the waterside shoulder of the levee.  
Fall 2017

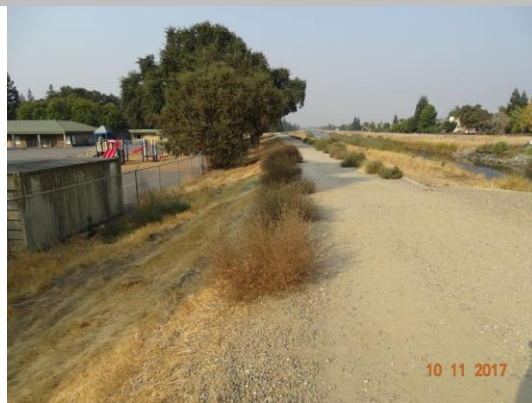
Photo 1 of 1 : FA\_2018\_NA0017\_152\_159\_20180926\_00030.jpg

LM Start	1.93	Rating **	M	Issue No.	159
LM End	1.96	Issue Type +	Ma	Location *	WS
Category	Earthen Levee			GPS Latitude/Longitude	
				Start	End
Item	Vegetation			38.042810 °	38.042815 °
				-121.348813 °	-121.348342 °
DWR ID	DWR_NA0017_08_f_2017_159				
Comment Code					
V2 : Remove the wild growth other than native grasses from the levee slopes.					
Inspector Comment

View of the vegetation on the waterside shoulder of the levee looking downstream. Fall 2017

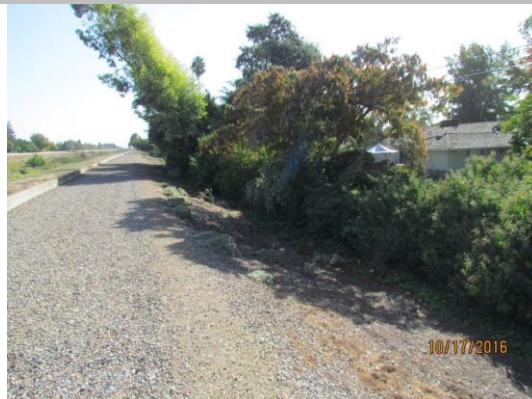
Photo 1 of 1 : FA\_2018\_NA0017\_152\_115\_20180926\_00019.jpg

LM Start	2.01	Rating **	M	Issue No.	115
LM End	2.11	Issue Type +	Ma	Location *	LS
Category	Earthen Levee			GPS Latitude/Longitude	
				Start	End
Item	Trim / Thin Trees			38.042801°	38.042778°
				-121.347390°	-121.345589°
DWR ID	DWR_NA0017_08_f_2016_115				
Comment Code					
T2 : Thin trees to allow visibility of the ground and room to flood fight.					
Inspector Comment

View of the tree limbs on the landside of the levee. Fall 2016.

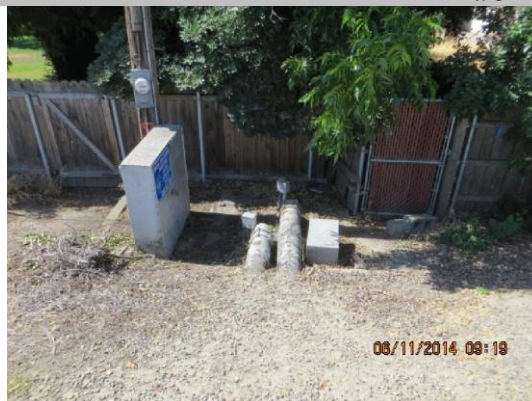
Photo 1 of 3 : UCIP\_FA\_2018\_38523\_70515.jpg

Pipe at pump and sump on LS toe next to Pole and electrical panel.

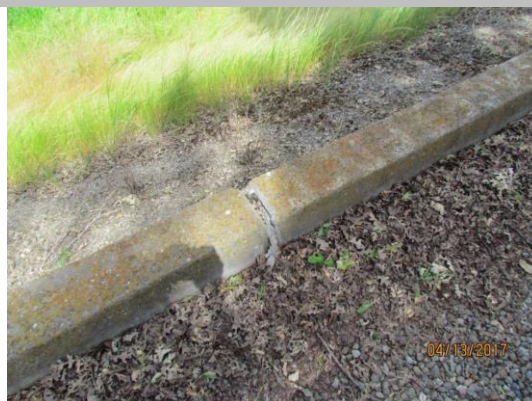
Photo 1 of 1 : FA\_2018\_NA0017\_152\_171\_20180926\_00036.jpg

LM Start	2.79	Rating **	M	Issue No.	171
LM End	2.79	Issue Type +	Ma	Location *	WS
Category	Concrete Floodwalls			GPS Latitude/Longitude	
				Start	End
Item	Monolith Joints			38.042710 °	38.042710 °
				-121.333020 °	-121.333020 °
DWR ID	DWR_NA0017_08_s_2017_171				
Comment Code					
Inspector Comment					
This portion of the floodwall has deteriorated monolith joints.

View of a deteriorated monolith joint on the waterside shoulder of the levee. Spring 2017

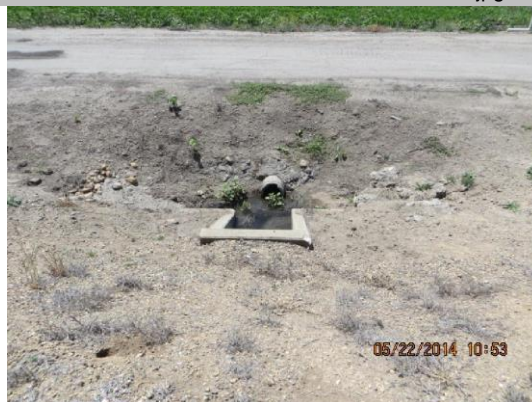
Photo 1 of 3 : UCIP\_FA\_2018\_38507\_70468.jpg

Headwall at LS toe.

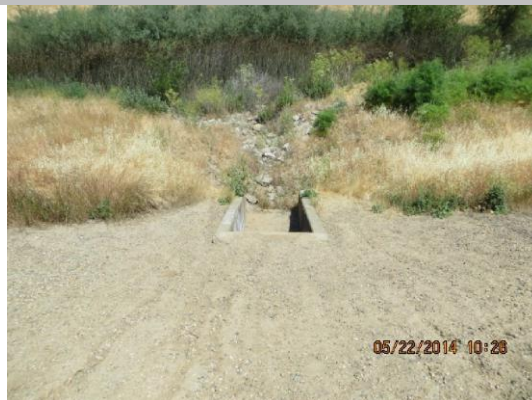
Photo 2 of 3 : UCIP\_FA\_2018\_38477\_70361.jpg

Headwall, flapgate, and grouted spillway on WS slope.

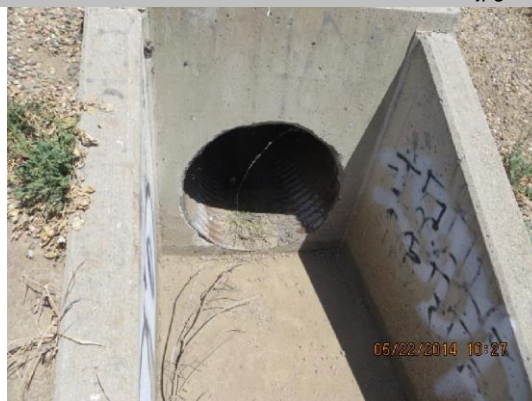
Photo 3 of 3 : UCIP\_FA\_2018\_38477\_70360.jpg

Headwall at LS toe.

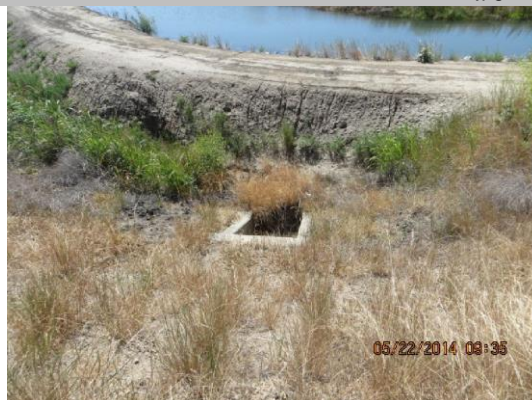
Photo 1 of 3 : UCIP\_FA\_2018\_38444\_70291.jpg

Headwall on LS toe.

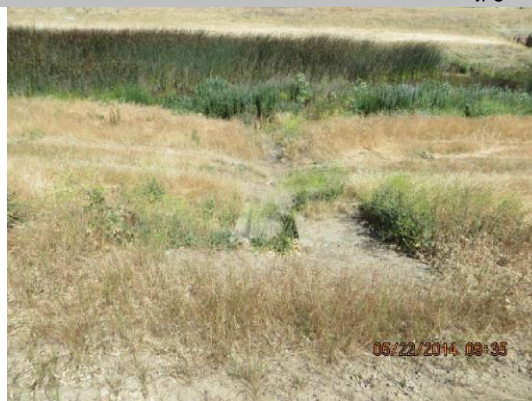
Photo 2 of 3 : UCIP\_FA\_2018\_38444\_70290.jpg

Headwall, flapgate, and grouted spillway on WS toe.

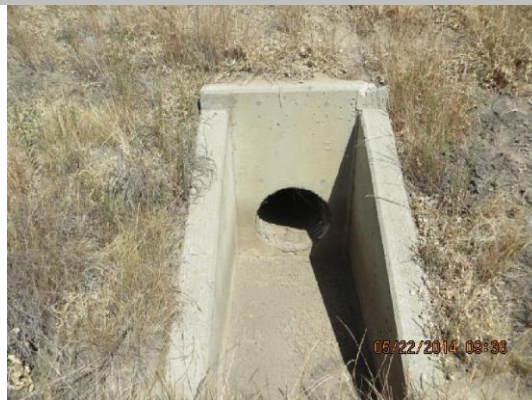
Photo 3 of 3 : UCIP\_FA\_2018\_38444\_70289.jpg

Headwall on LS toe.

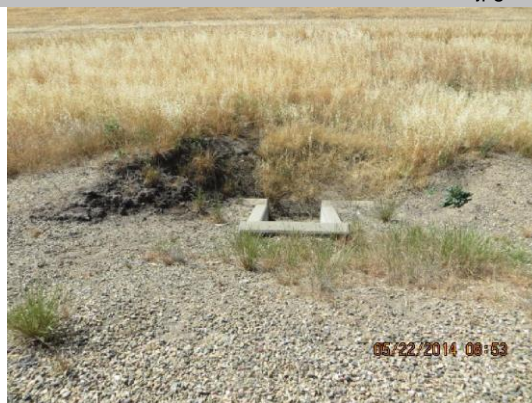
Photo 1 of 3 : UCIP\_FA\_2018\_38367\_70024.jpg

Headwall on LS toe.

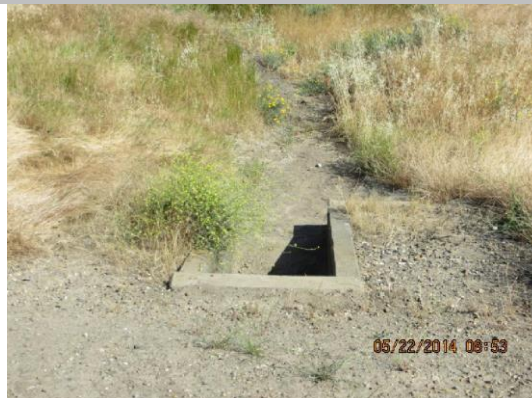
Photo 2 of 3 : UCIP\_FA\_2018\_38367\_70023.jpg

Headwall, flapgate, and grouted spillway on WS toe.

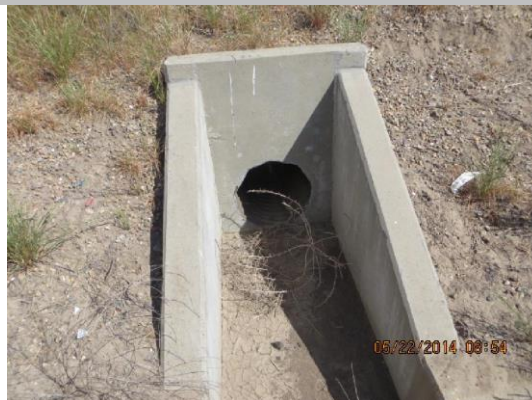
Photo 3 of 3 : UCIP\_FA\_2018\_38367\_70022.jpg

Headwall on LS toe.

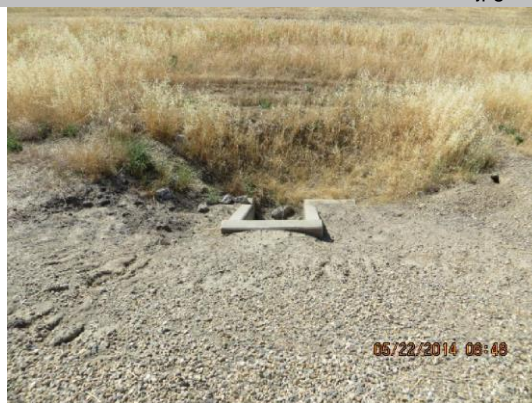
Photo 1 of 3 : UCIP\_FA\_2018\_38365\_70019.jpg

Headwall on LS toe.

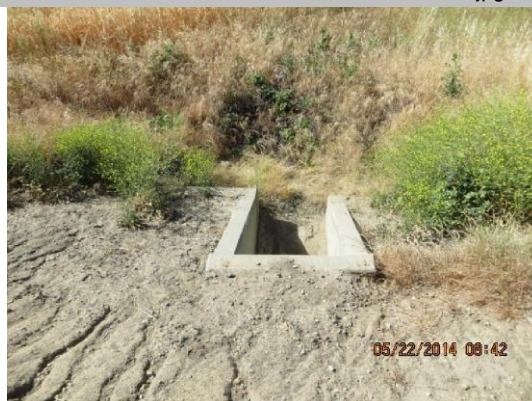
Photo 1 of 3 : UCIP\_FA\_2018\_38363\_70010.jpg

Headwall on LS toe.

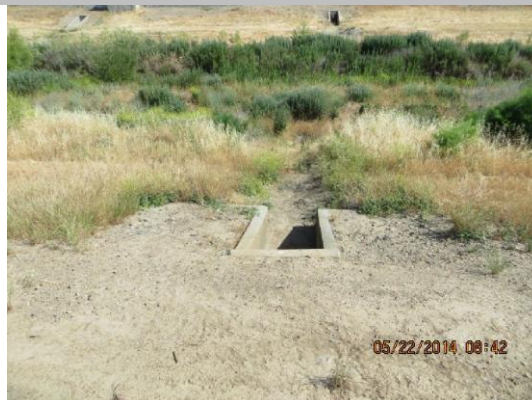
Photo 2 of 3 : UCIP\_FA\_2018\_38363\_70009.jpg

Headwall, flapgate, and grouted spillway on WS toe.

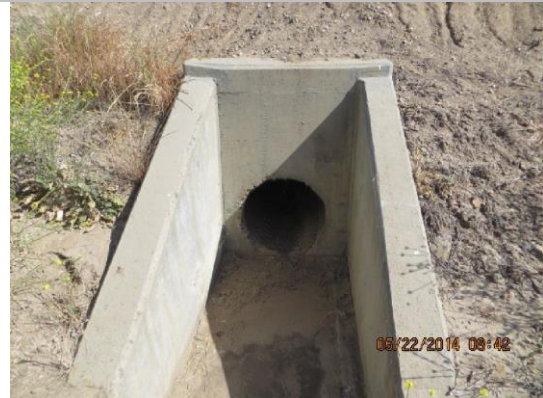
Photo 3 of 3 : UCIP\_FA\_2018\_38363\_70008.jpg

Headwall on LS toe.

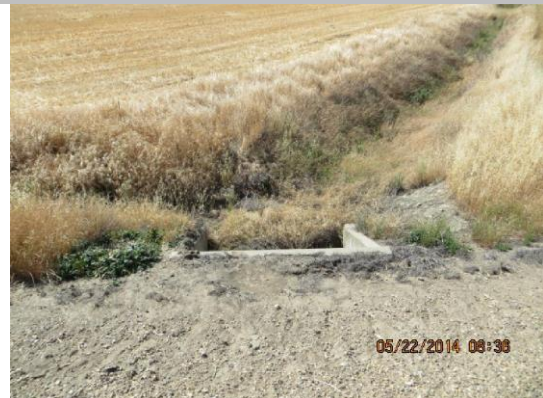
Photo 1 of 3 : UCIP\_FA\_2018\_38361\_70005.jpg

Headwall on LS toe.

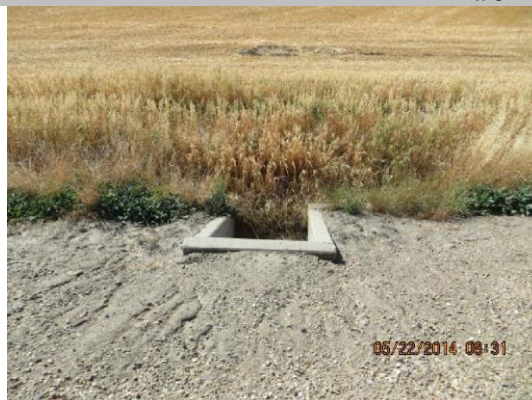
Photo 1 of 3 : UCIP\_FA\_2018\_38359\_69995.jpg

Headwall on LS toe.

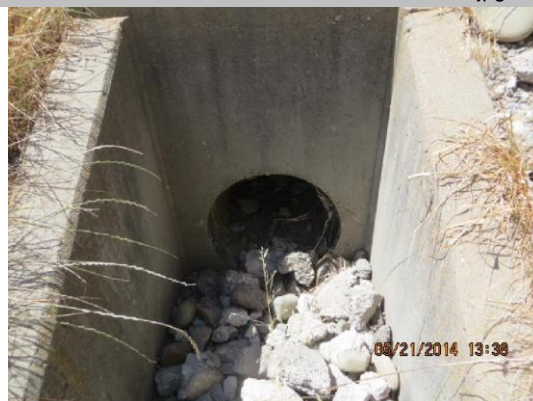
Photo 3 of 3 : UCIP\_FA\_2018\_41809\_69978.jpg

Comment Code						
Inspector Comment						
FS_ID:41809						
DS_ID:23743						
EP_NO: N/A						
Repair Type: Non-Urgent						
Crossing Status: Found						
UCIP Comments: Cobbles building up at inlet and inside pipe along with sediment.						
FIELD_STRUCT_DESC: 24-inch corrugated metal storm drainage pipe through the levee, 7 feet below the crown. Flap gate on the waterside (WS) end. Concrete U-shaped headwalls on both ends. Cobble grouted spillway across the berm. Cobble grouted apron on the landside (LS) end. [Additional Reference(s): DWR Levee Log, 1990. USACE San Joaquin O&M Manual 612.2, 1967, (HLM 7.65) and 612 (addendum), February 1999, (HLM 7.70) (Station 406+58)].						
FS Date: 5/21/2014

Concrete headwall on LS toe. Cobbles distributed at inlet.
