**Flood Control Project Maintenance  
Levee Inspections**

**Maintenance Issue Types Only, Levee Inspection Report By Mile - Fall 2018**

**San Joaquin County Flood Control and Water Conservation District**

Waterway	Bank	Unit Miles	Inspection Start/End	Inspector
Unit No. 01 Littlejohn Creek	Left	2.59	10/18/2018 10/18/2018	Wade Wylie

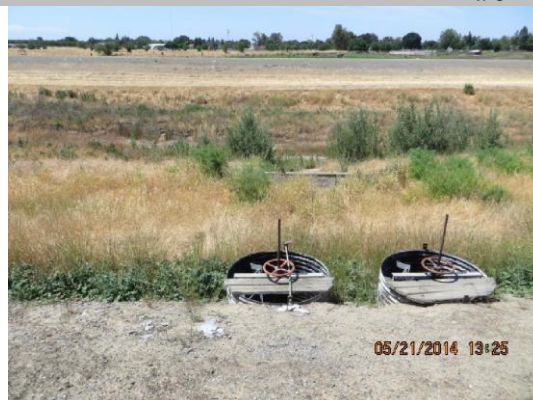
Photo 1 of 3 : UCIP\_FA\_2018\_38352\_69974.jpg

Comment Code						
Inspector Comment						
FS_ID:38352						
DS_ID:23744						
EP_NO: N/A						
Repair Type: Non-Urgent						
Crossing Status: Found						
UCIP Comments: Lid damaged/missing from CMP riser on WS slope.						
FIELD_STRUCT_DESC: 1 of 2: 36-inch corrugated metal storm						
drainage pipe through the levee, 9 feet below the crown. Flap gate on						
the waterside (WS) end. Slide gate in 48-inch corrugated metal riser						
unit on the WS slope. Concrete U-shaped headwalls on both ends.						
Cobble grouted spillway on the channel bank. Cobble grouted apron in						
ditch on the landside (LS). [Additional Reference(s): DWR Levee Log,						
1990. USACE San Joaquin O&M Manual 612.2, 1967, (HLM 8.18) and						
612 (addendum), February 1999, (HLM 8.21) (Station 433+70)].						
FS Date: 5/21/2014

Slide gate in CMP riser on WS slope. Lid missing/damaged.

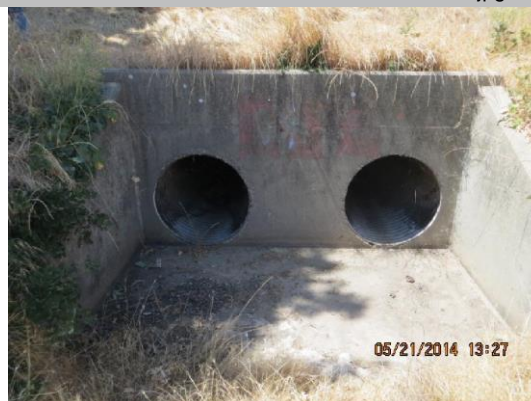
Photo 3 of 3 : UCIP\_FA\_2018\_38351\_69966.jpg

Headwall on LS toe at drainage channel.

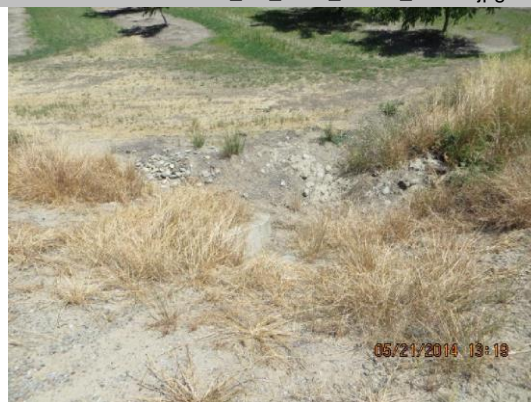
Photo 1 of 3 : UCIP\_FA\_2018\_38350\_69963.jpg

Headwall and grouted apron on LS toe.

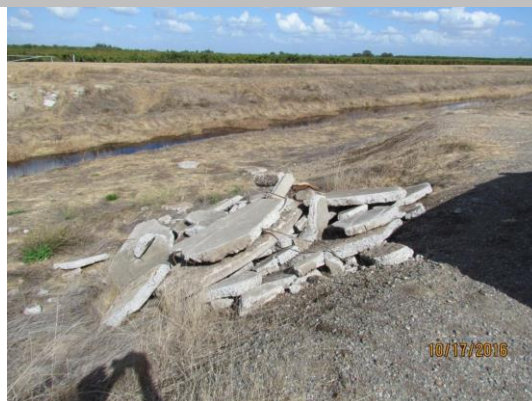
Photo 1 of 1 : FA\_2018\_NA0017\_152\_126\_20180926\_00020.jpg

LM Start	8.43	Rating **	M	Issue No.	126
LM End	8.43	Issue Type +	Ma	Location *	WS
Category	Earthen Levee			GPS Latitude/Longitude	
				Start	End
Item	Encroachments			38.066939 °	38.066939 °
				-121.242196 °	-121.242196 °
DWR ID	DWR_NA0017_08_f_2016_126				
Comment Code					
DE : Debris					
Inspector Comment					
Concrete Debris

View of concrete debris on the waterside of the levee. Fall 2016.

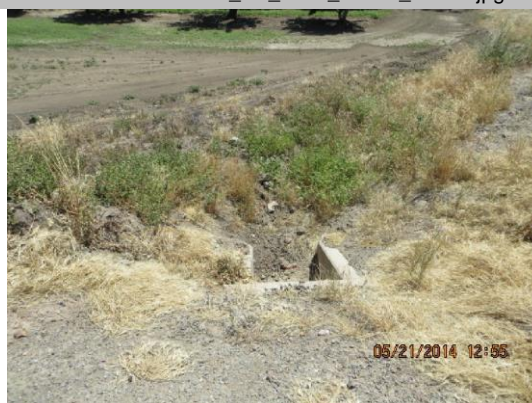
Photo 1 of 3 : UCIP\_FA\_2018\_38346\_69954.jpg

Headwall at LS toe.

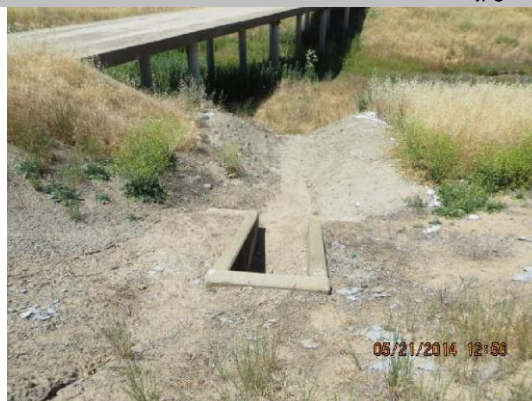
Photo 2 of 3 : UCIP\_FA\_2018\_38346\_69953.jpg

Headwall, flapgate, and grouted spillway on WS slope.

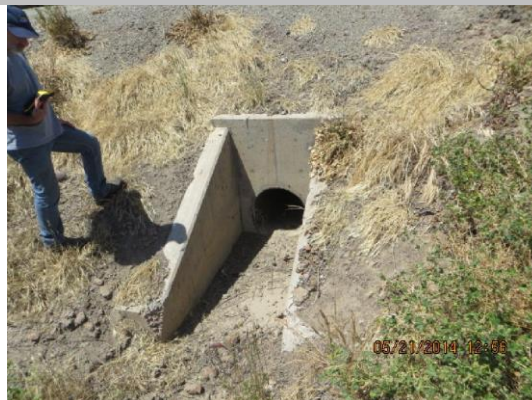
Photo 3 of 3 : UCIP\_FA\_2018\_38346\_69952.jpg

Headwall at LS toe.

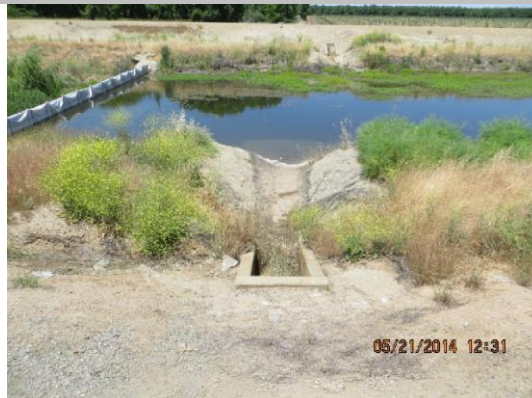
Photo 1 of 3 : UCIP\_FA\_2018\_38241\_69739.jpg

Headwall, flapgate, and grouted spillway on WS slope.

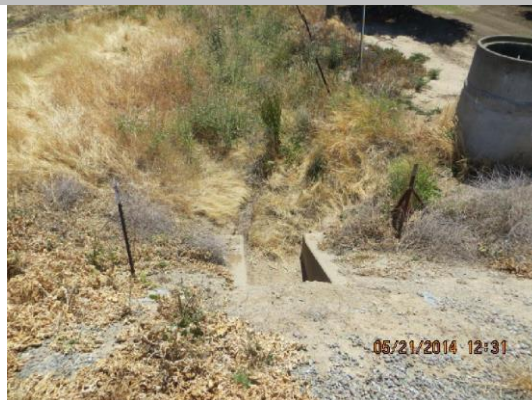
Photo 2 of 3 : UCIP\_FA\_2018\_38241\_69738.jpg

Headwall at LS toe.

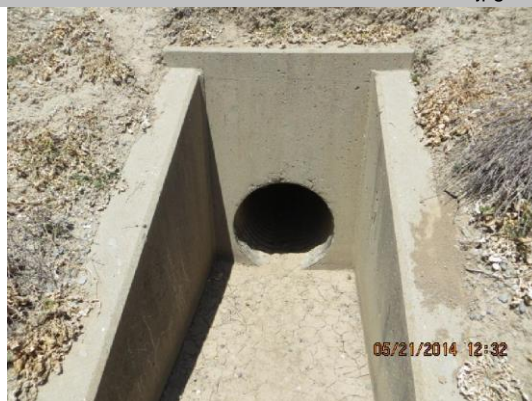
Photo 3 of 3 : UCIP\_FA\_2018\_38241\_69737.jpg

Headwall at LS toe.

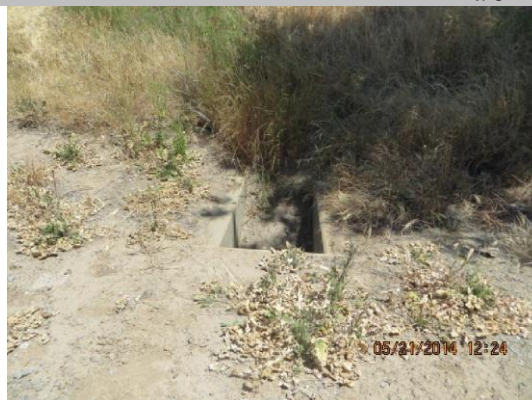
Photo 1 of 3 : UCIP\_FA\_2018\_38239\_69728.jpg

Comment Code					
Inspector Comment					
FS_ID:38239					
DS_ID:23727					
EP_NO: N/A					
Repair Type: Non-Urgent					
Crossing Status: Found					
UCIP Comments: Sediment and debris buildup inside pipe on LS toe.					
FIELD_STRUCT_DESC: 24-inch corrugated metal storm drainage pipe					
through the levee, 7 feet below the crown. Flap gate on the waterside					
(WS) end. Concrete U-shaped headwalls on both ends. Cobble grouted					
spillway across the berm. Cobble grouted apron on the landside (LS)					
end. [Additional Reference(s): DWR Levee Log, 1990. USACE San					
Joaquin O&M Manual 612.2, 1967, (HLM 10.09) and 612 (addendum),					
February 1999, (HLM 10.00) (Station 528+18)].					
FS Date: 5/21/2014

Headwall at LS toe.

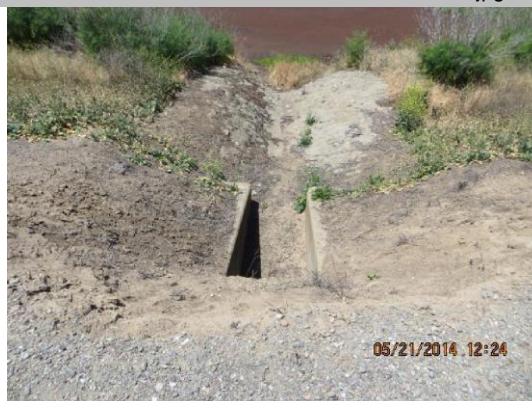
Photo 2 of 3 : UCIP\_FA\_2018\_38239\_69727.jpg

Headwall, flapgate, and grouted spillway on WS slope.

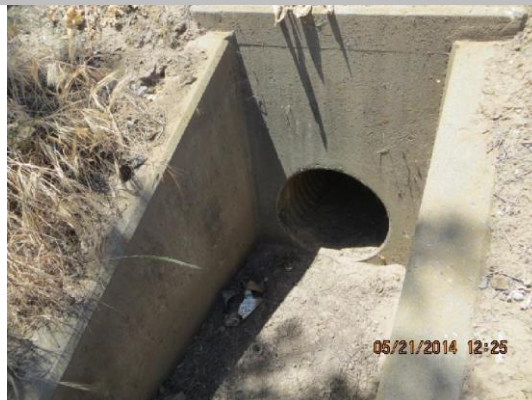
Photo 3 of 3 : UCIP\_FA\_2018\_38239\_69726.jpg

Headwall at LS toe.

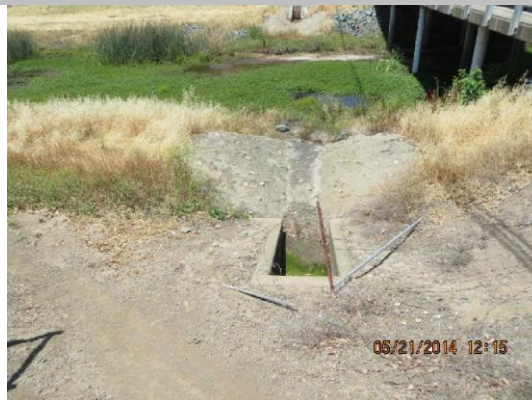
Photo 2 of 3 : UCIP\_FA\_2018\_38232\_69705.jpg

Headwall, flapgate, and grouted spillway on WS slope.

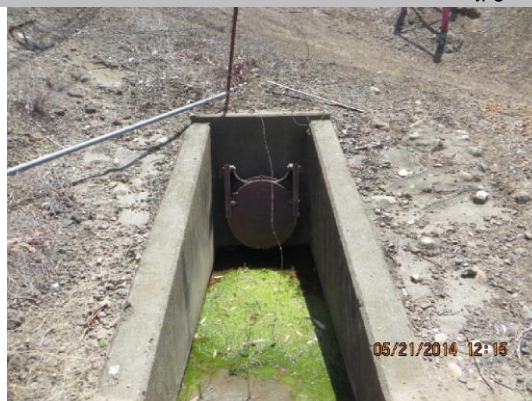
Photo 3 of 3 : UCIP\_FA\_2018\_38232\_69704.jpg

Headwall and flapgate on WS slope.

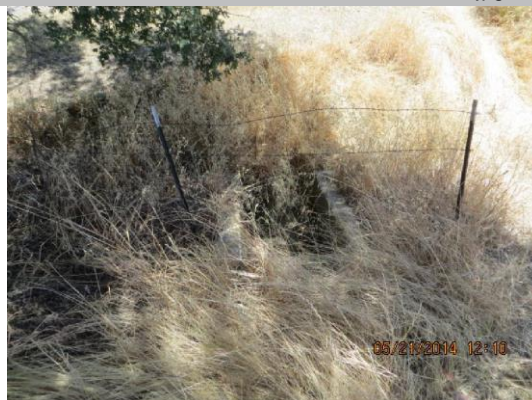
Photo 1 of 3 : UCIP\_FA\_2018\_41808\_69701.jpg

Comment Code					
Inspector Comment					
FS_ID:41808					
DS_ID:23729					
EP_NO: N/A					
Repair Type: Non-Urgent					
Crossing Status: Found					
UCIP Comments: Some sediment buildup in pipe at LS toe.					
FIELD_STRUCT_DESC: 24-inch corrugated metal storm drainage pipe through the levee, 7 feet below the crown. Flap gate on the waterside (WS) end. Concrete U-shaped headwalls on both ends. Cobble grouted spillway across the berm. Cobble grouted apron on the landside (LS) end. [Additional Reference(s): DWR Levee Log, 1990. USACE San Joaquin O&M Manual 612.2, 1967, (HLM 10.48) and 612 (addendum), February 1999, (HLM 10.46) (Station 552+17)].					
FS Date: 5/21/2014

Headwall at LS toe.

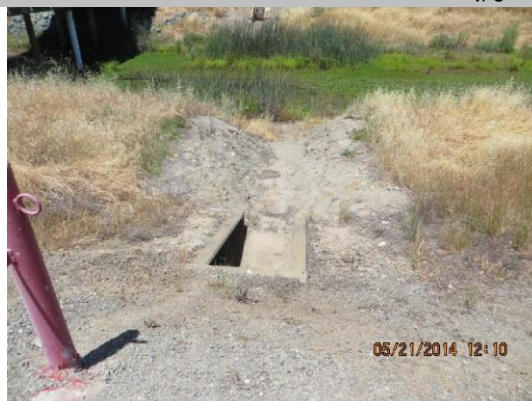
Photo 2 of 3 : UCIP\_FA\_2018\_41808\_69700.jpg

Headwall, flapgate, and grouted spillway on WS slope.

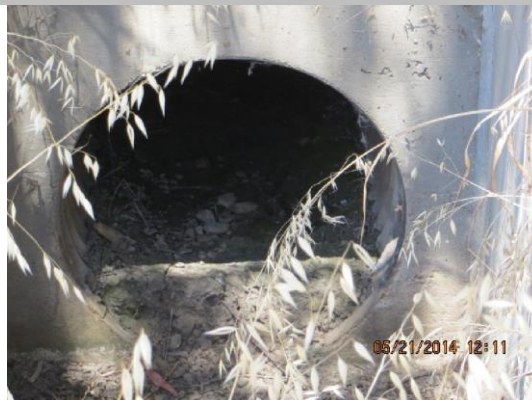
Photo 3 of 3 : UCIP\_FA\_2018\_41808\_69703.jpg

Headwall at LS toe.

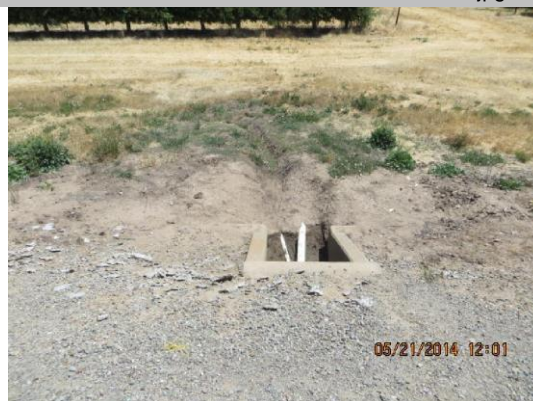
Photo 1 of 3 : UCIP\_FA\_2018\_38229\_69693.jpg

Headwall with two PVC discharge pipes at LS toe.

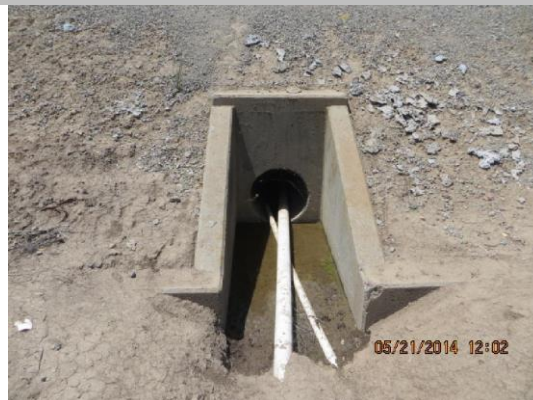
Photo 2 of 3 : UCIP\_FA\_2018\_38229\_69692.jpg

Headwall with two PVC discharge pipes at LS toe.

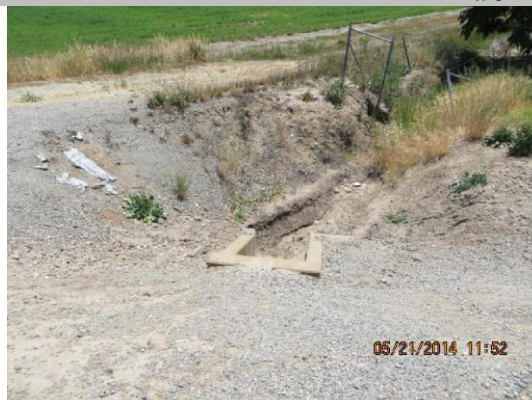
Photo 1 of 3 : UCIP\_FA\_2018\_41810\_69684.jpg

Headwall at LS toe.

Item	DWR UCIP LMA Responsibility			38.078140 °		38.078140 °
				-121.205820 °		-121.205820 °
DWR ID	23749					
Comment Code						
Inspector Comment						
FS_ID:41810 DS_ID:23749 EP_NO: N/A Repair Type: Non-Urgent Crossing Status: Found UCIP Comments: Some silt buildup in pipe at LS toe. FIELD_STRUCT_DESC: 24-inch corrugated metal storm drainage pipe through the levee, 8 feet below the crown. Flap gate on the waterside (WS) end. Concrete U-shaped headwalls on both ends. Cobble grouted spillway across the berm. Cobble grouted apron on the landside (LS) end. [Additional Reference(s): DWR Levee Log, 1990. USACE San Joaquin O&M Manual 612.2, 1967, (HLM 10.97) and 612 (addendum), February 1999, (HLM 10.94) (Station 577+59)]. FS Date: 5/21/2014

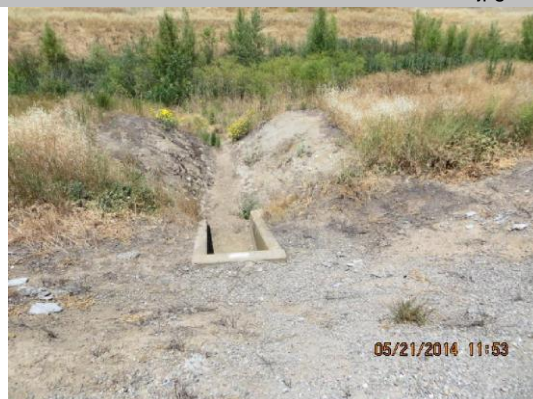
Photo 2 of 3 : UCIP\_FA\_2018\_41810\_69683.jpg

Headwall, flapgate, and grouted spillway on WS slope.

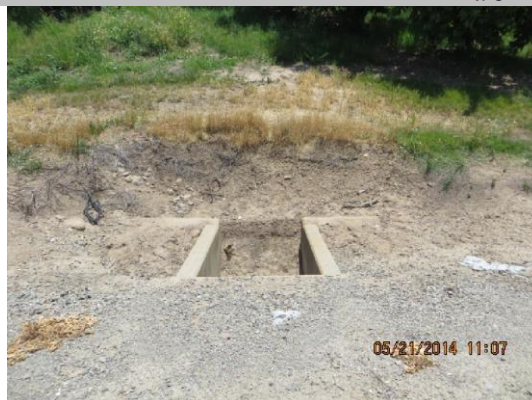
Photo 1 of 3 : UCIP\_FA\_2018\_38223\_69662.jpg

Headwall and grouted intake on LS toe.

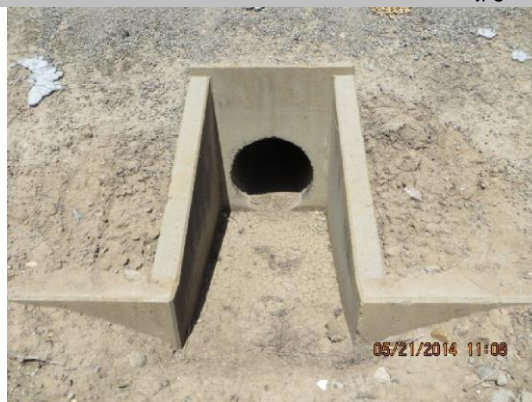
Photo 3 of 3 : UCIP\_FA\_2018\_38223\_69660.jpg

Headwall on LS toe.

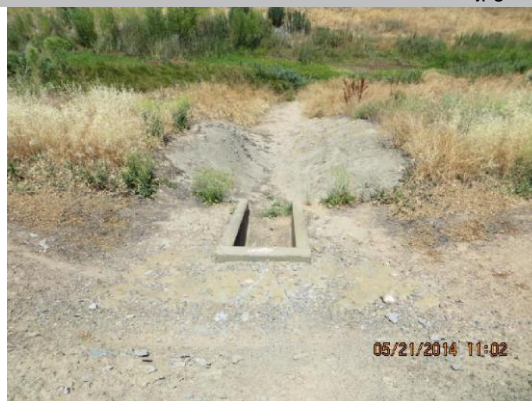
Photo 2 of 3 : UCIP\_FA\_2018\_38221\_69658.jpg

Headwall, flapgate, and grouted spillway on WS slope.

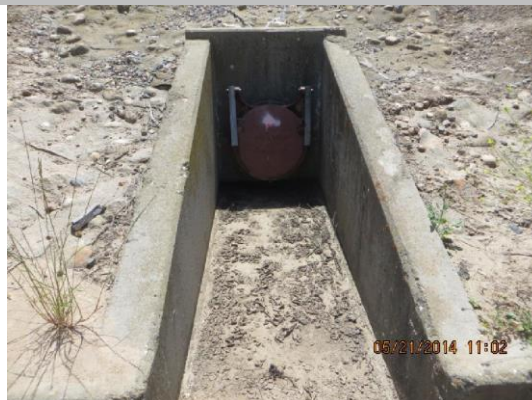
Photo 3 of 3 : UCIP\_FA\_2018\_38221\_69657.jpg

Headwall and flapgate on WS slope.

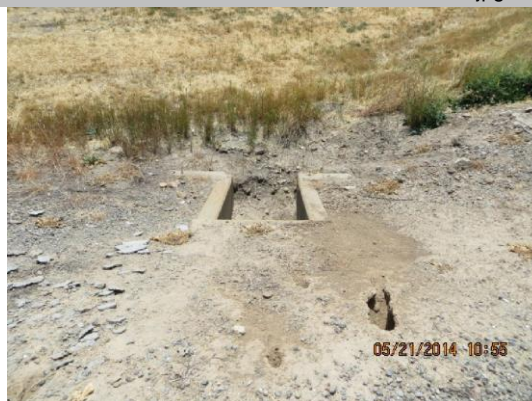
Photo 1 of 3 : UCIP\_FA\_2018\_51700\_69653.jpg

Headwall at LS toe.

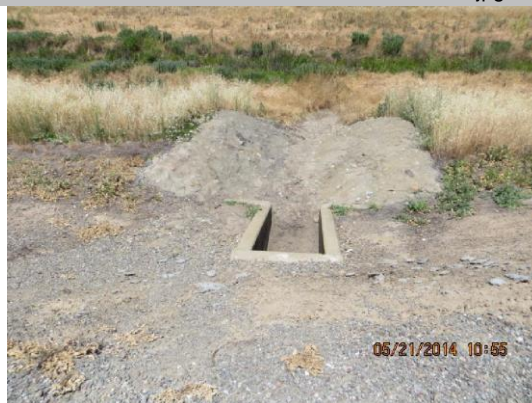
Photo 2 of 3 : UCIP\_FA\_2018\_51700\_69652.jpg

Headwall, flapgate, and grouted spillway on WS slope.

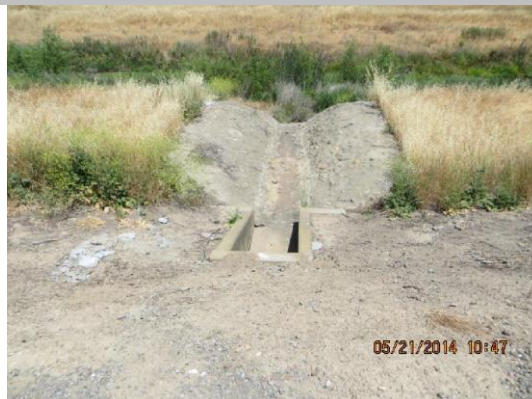
Photo 2 of 3 : UCIP\_FA\_2018\_51701\_69647.jpg

Headwall, flapgate, and grouted spillway on WS slope.

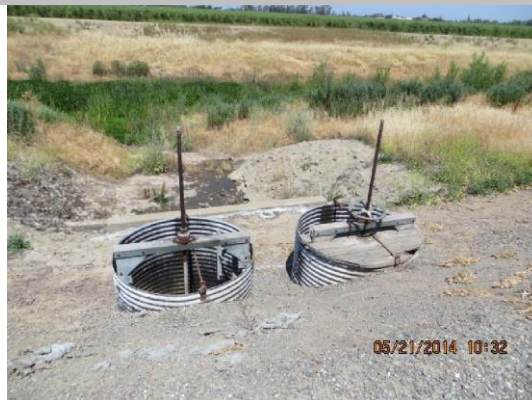
Photo 2 of 3 : UCIP\_FA\_2018\_38216\_69638.jpg

Comment Code						
Inspector Comment						
FS_ID:38216						
DS_ID:23756						
EP_NO: N/A						
Repair Type: Non-Urgent						
Crossing Status: Found						
UCIP Comments: CMP riser missing cover on WS slope.						
FIELD_STRUCT_DESC: 1 of 2: 48-inch corrugated metal storm drainage pipe through the levee, 8.5 feet below the crown. Slide gate in 60-inch corrugated metal riser unit on the waterside (WS) slope. Concrete U-shaped headwalls on both ends. Cobble grouted spillway on the WS end. Cobble grouted apron on the landside (LS) end. [Additional Reference(s): DWR Levee Log, 1990. USACE San Joaquin O&M Manual 612.2, 1967, (HLM 12.20) and 612 (addendum), February 1999, (HLM 12.13) (Station 640+50)].						
FS Date: 5/21/2014

Slide gate in CMP riser on WS slope missing cover.

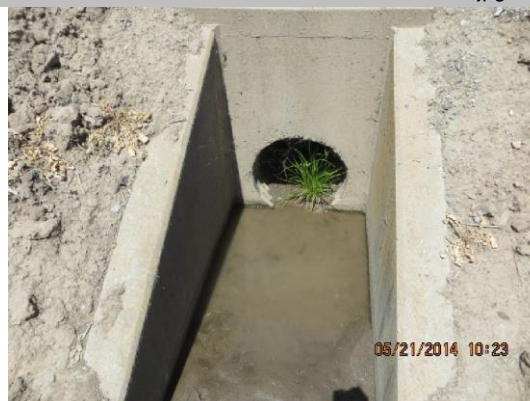
Photo 3 of 3 : UCIP\_FA\_2018\_41811\_69619.jpg

Headwall on LS toe.

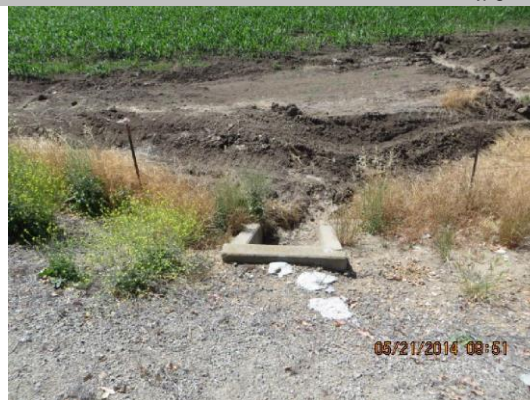
Photo 1 of 3 : UCIP\_FA\_2018\_38210\_69610.jpg

Headwall on LS toe.

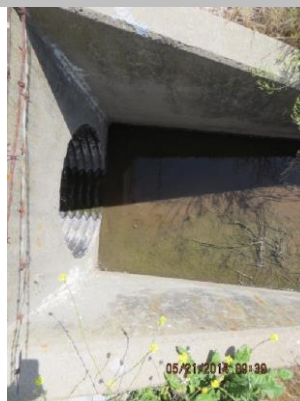
Photo 3 of 3 : UCIP\_FA\_2018\_38206\_69600.jpg

Headwall at LS toe.

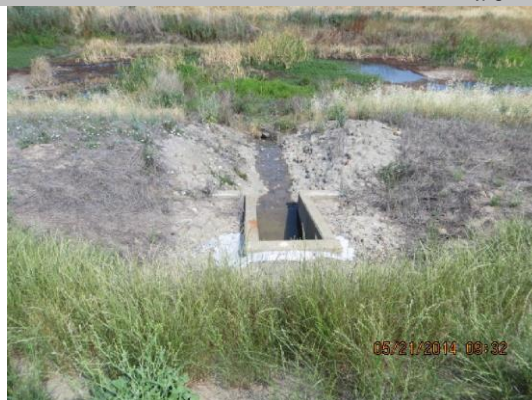
Photo 1 of 3 : UCIP\_FA\_2018\_38205\_69591.jpg

LM Start	12.63	Rating **	A/W	Issue No.	1177	
LM End	12.63	Issue Type +	Ma	Location *		
Category	Supplemental			GPS Latitude/Longitude		
				Start		End
Item	DWR UCIP LMA Responsibility			38.092598 °		38.092598 °
				-121.177228 °		-121.177228 °
DWR ID	23765					
Comment Code						
Inspector Comment						
FS_ID:38205						
DS_ID:23765						
EP_NO: N/A						
Repair Type: No Action Needed						
Crossing Status: Found						
UCIP Comments:						
FIELD_STRUCT_DESC: 24-inch corrugated metal drainage pipe through the levee, 9 feet below the crown. Flap gate on the waterside (WS) end. Slide gate on the landside (LS) end. Concrete U-shaped headwalls on both ends. Cobble grouted spillway across the berm. Cobble grouted apron on the LS end. [Additional Reference(s): DWR Levee Log, 1990. USACE San Joaquin O&M Manual 612.2, 1967, (HLM 13.00)].						
FS Date: 5/21/2014

Headwall, flapgate, and grouted spillway on WS slope.

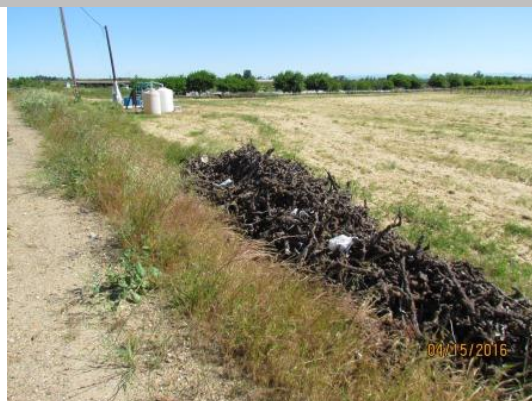
Photo 1 of 1 : FA\_2018\_NA0017\_152\_133\_20180926\_00022.jpg

LM Start	12.84	Rating **	M	Issue No.	133
LM End	12.84	Issue Type +	Ma	Location *	WS
Category	Earthen Levee			GPS Latitude/Longitude	
				Start	End
Item	Encroachments			38.096581°	38.096581°
				-121.175898°	-121.175898°
DWR ID	DWR_NA0017_08_s_2015_133				
Comment Code					
DE : Debris					
Inspector Comment					
Trash on the waterside berm.

View of prunings on the landside toe of the levee.

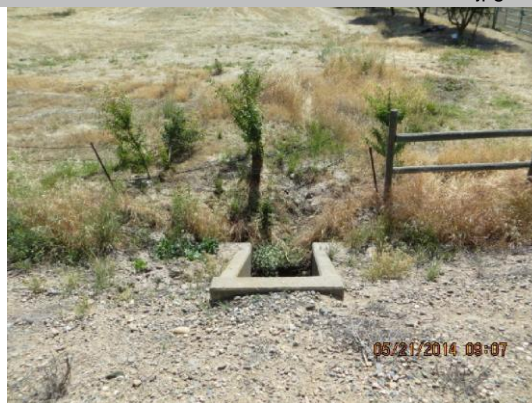
Photo 1 of 3 : UCIP\_FA\_2018\_38203\_69582.jpg

LM Start	12.89	Rating **	A/W	Issue No.	1179
LM End	12.89	Issue Type +	Ma	Location *	
Category	Supplemental			GPS Latitude/Longitude	
				Start	End
Item	DWR UCIP LMA Responsibility			38.097279 °	38.097279 °
				-121.175854 °	-121.175854 °
DWR ID	23767				
Comment Code					
Inspector Comment					
FS_ID:38203 DS_ID:23767 EP_NO: N/A Repair Type: No Action Needed Crossing Status: Found UCIP Comments: FIELD_STRUCT_DESC: 24-inch corrugated metal drainage pipe through the levee, 7 feet below the crown. Concrete U-shaped headwall on both ends. Flap gate on the waterside (WS) end. Cobble grouted spillway. Cobble grouted intake on the landside (LS). [Additional Reference(s): DWR Levee Log, 1990. USACE San Joaquin O&M Manual 612.2, 1967, (HLM 13.26)]. FS Date: 5/21/2014

Concrete headwall on LS toe.

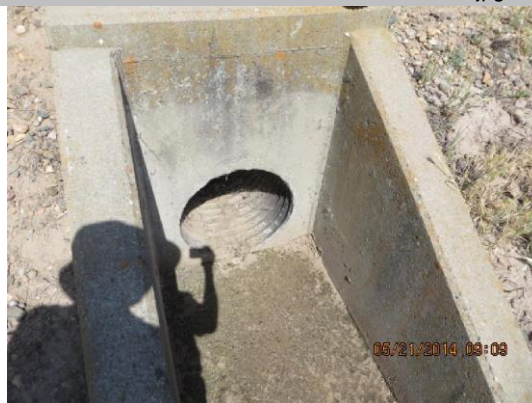
Photo 3 of 3 : UCIP\_FA\_2018\_38203\_69580.jpg

Concrete headwall on LS toe.

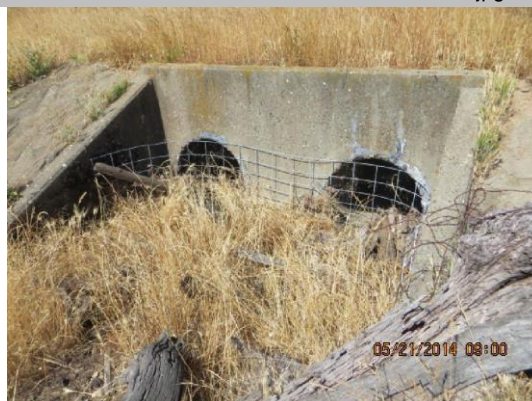
Photo 3 of 3 : UCIP\_FA\_2018\_38144\_69424.jpg

Headwall on LS toe. Note debris buildup.

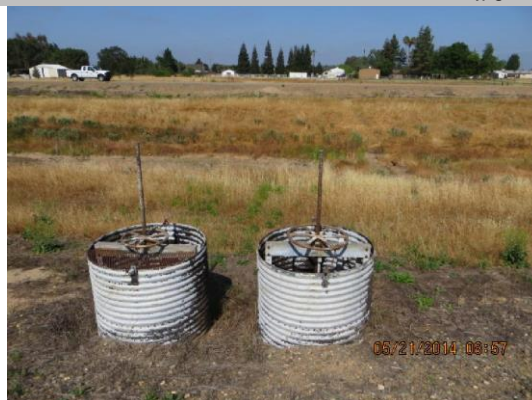
Photo 1 of 3 : UCIP\_FA\_2018\_38143\_69422.jpg

LM Start	12.98	Rating **	M	Issue No.	1181	
LM End	12.98	Issue Type +	Ma	Location *		
Category	Supplemental			GPS Latitude/Longitude		
				Start		End
Item	DWR UCIP LMA Responsibility			38.098582 °		38.098582 °
				-121.175703 °		-121.175703 °
DWR ID	23816					
Comment Code						
Inspector Comment						
FS_ID:38143						
DS_ID:23816						
EP_NO: N/A						
Repair Type: Non-Urgent						
Crossing Status: Found						
UCIP Comments: Some debris buildup at inlet and no lid on standpipe at WS shoulder.						
FIELD_STRUCT_DESC: 2 of 2: 36-inch corrugated metal drainage pipe through the levee, 10 feet below the crown. Concrete U-shaped headwall on both ends. Slide gate in corrugated metal riser unit on the waterside (WS) slope. Flap gate on the WS end. [Additional Reference(s): DWR Levee Log, 1990. USACE San Joaquin O&M Manual 612.2, 1967, (HLM 13.35)].						
FS Date: 5/21/2014

Slide gate in CMP riser on WS slope.

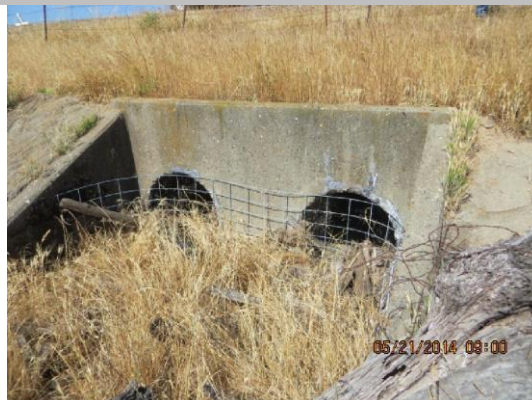
Photo 3 of 3 : UCIP\_FA\_2018\_38143\_69420.jpg

Headwall on LS toe. Note debris buildup.

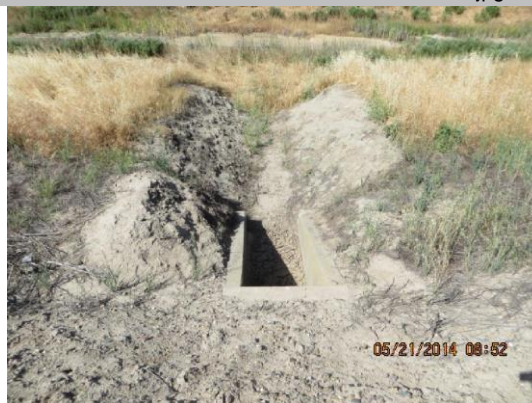
Photo 2 of 3 : UCIP\_FA\_2018\_38141\_69417.jpg

Headwall, flapgate, and grouted spillway on WS slope.

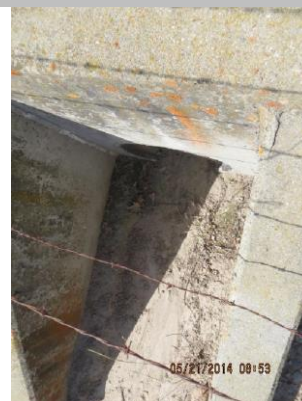
Photo 3 of 3 : UCIP\_FA\_2018\_38141\_69416.jpg

Headwall on LS toe.

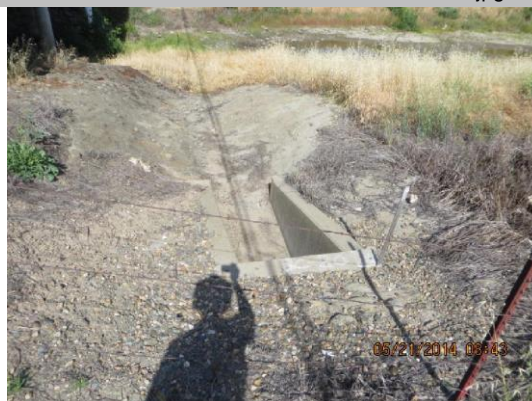
Photo 2 of 3 : UCIP\_FA\_2018\_38140\_69412.jpg

Headwall, flapgate, and grouted spillway on WS slope.

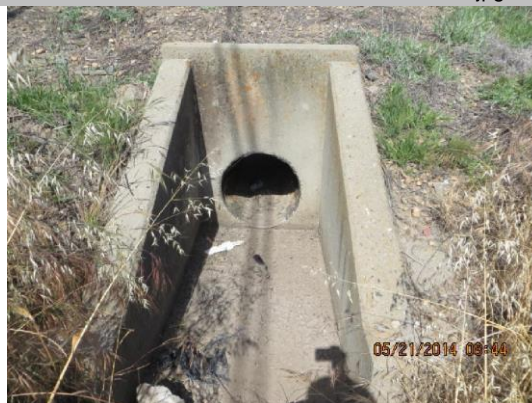
Photo 3 of 3 : UCIP\_FA\_2018\_38140\_69411.jpg

Headwall on LS toe.

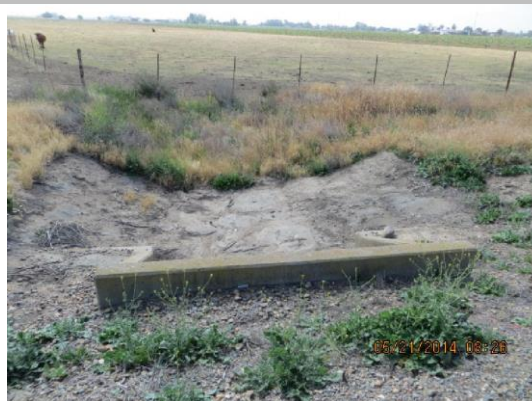
Photo 2 of 3 : UCIP\_FA\_2018\_38136\_69395.jpg

Headwall on LS toe.

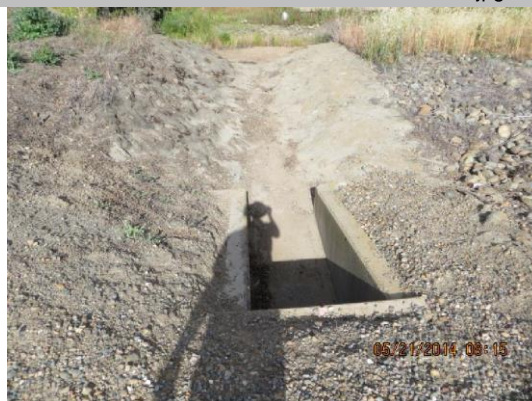
Photo 2 of 3 : UCIP\_FA\_2018\_38134\_69388.jpg

Headwall, flapgate, and grouted spillway on WS slope.

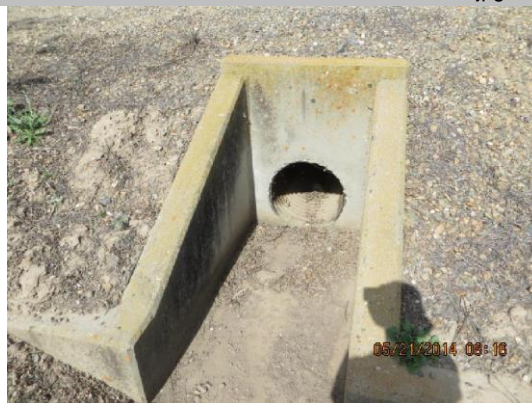
Photo 3 of 3 : UCIP\_FA\_2018\_38134\_69387.jpg

Headwall at LS toe.

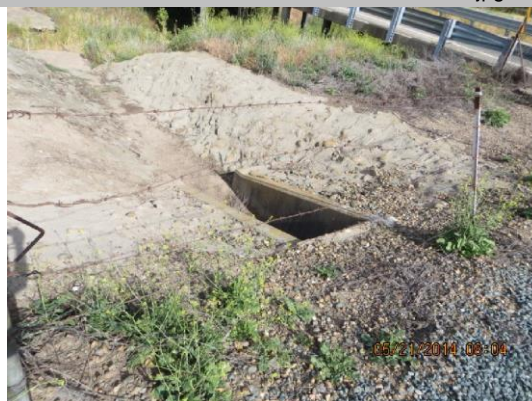
Photo 1 of 3 : UCIP\_FA\_2018\_38130\_69375.jpg

Headwall, flapgate, and grouted spillway on WS slope.

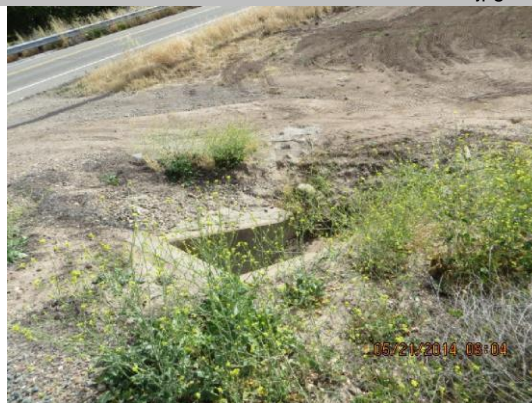
Photo 2 of 3 : UCIP\_FA\_2018\_38130\_69374.jpg

Headwall on LS toe.

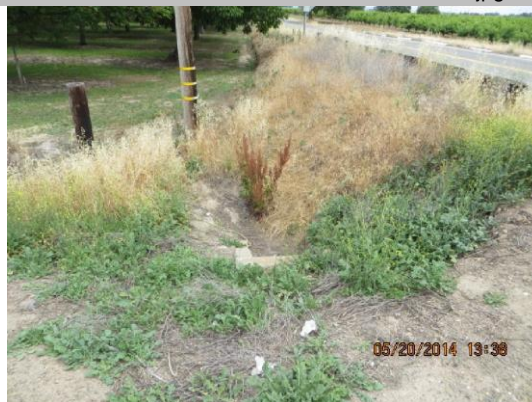
Photo 1 of 3 : UCIP\_FA\_2018\_38129\_69370.jpg

Headwall on LS toe.

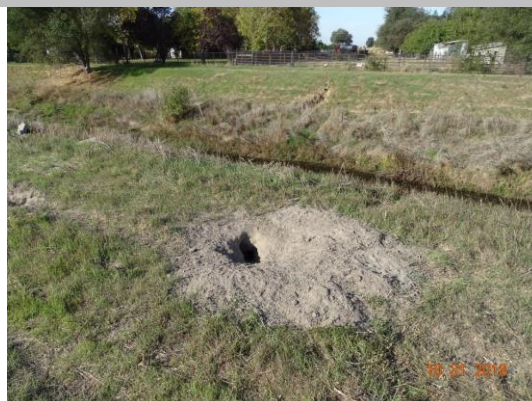
Photo 1 of 1 : FA\_2018\_NA0017\_152\_132\_20181105\_00325.jpg

LM Start	14.67	Rating **	U	Issue No.	132
LM End	14.67	Issue Type +	Ma	Location *	WS
Category	Earthen Levee			GPS Latitude/Longitude	
				Start	End
Item	Animal Control			38.121026 °	38.121026 °
				-121.169395 °	-121.169395 °
DWR ID	DWR_NA0017_08_f_2018_132				
Comment Code					
A3 : No rodents visible, but rodent burrows visible; need to backfill and compact or grout burrows.					
Inspector Comment					
Large rodent hole on the waterside shoulder.

View of rodent hole on the waterside shoulder. Fall 2018.

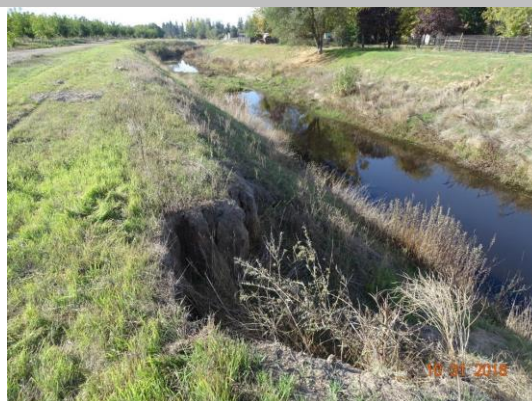
Photo 1 of 1 : FA\_2018\_NA0017\_152\_134\_20181105\_00326.jpg

LM Start	14.67	Rating **	M	Issue No.	134
LM End	14.67	Issue Type +	Ma	Location *	WS
Category	Earthen Levee			GPS Latitude/Longitude	
				Start	End
Item	Erosion / Bank Caving			38.121103°	38.121103°
				-121.169363°	-121.169363°
DWR ID	DWR_NA0017_08_f_2018_134				
Comment Code					
E2 : Schedule repair of erosion site prior to the next inspection.					
Inspector Comment					
Erosion on the waterside slope.

View of erosion on the waterside slope. Fall 2018.

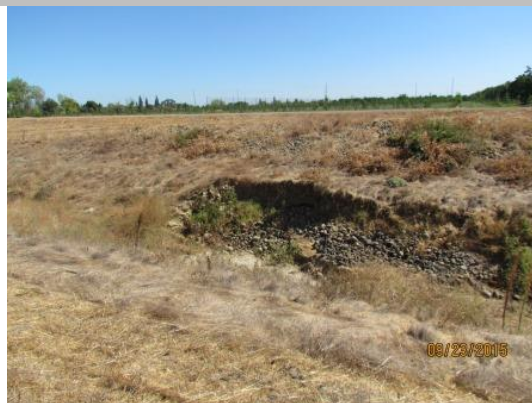
Photo 1 of 1 : FA\_2018\_NA0017\_152\_57\_20180926\_00008.jpg

LM Start	14.75	Rating **	M	Issue No.	57
LM End	14.75	Issue Type +	Ma	Location *	WS
Category	Earthen Levee			GPS Latitude/Longitude	
				Start	End
Item	Erosion / Bank Caving			38.122151°	38.122151°
				-121.169029°	-121.169029°
DWR ID	DWR_NA0017_08_f_2015_57				
Comment Code					
E2 : Schedule repair of erosion site prior to the next inspection.					
Inspector Comment					
Waterside toe erosion.

Erosion was found on the waterside toe of the levee. The picture was taken from the right bank of the levee.

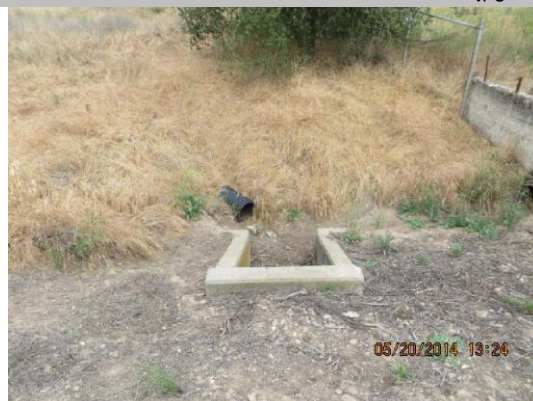
Photo 1 of 3 : UCIP\_FA\_2018\_38126\_69357.jpg

Headwall at LS toe.

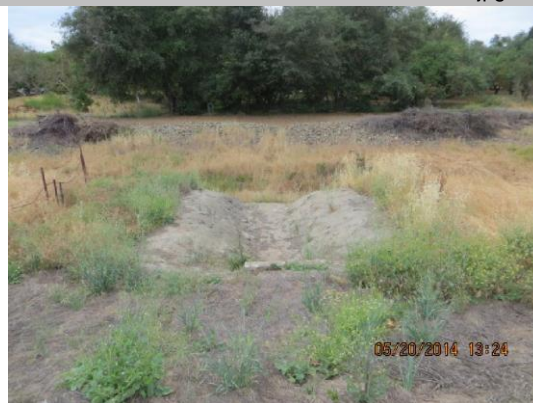
Photo 2 of 3 : UCIP\_FA\_2018\_38126\_69356.jpg

Headwall, flapgate, and grouted spillway on WS toe.

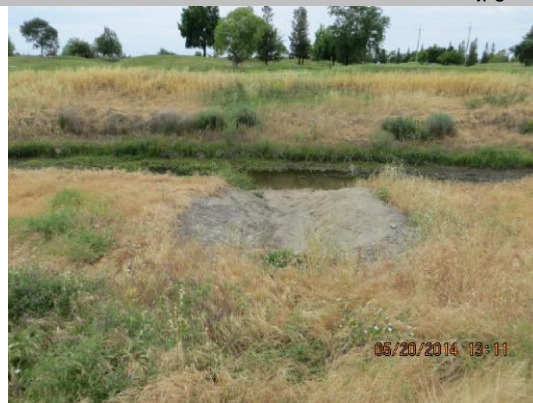
Photo 2 of 3 : UCIP\_FA\_2018\_38125\_69351.jpg

Headwall, flapgate, and grouted spillway on WS toe.

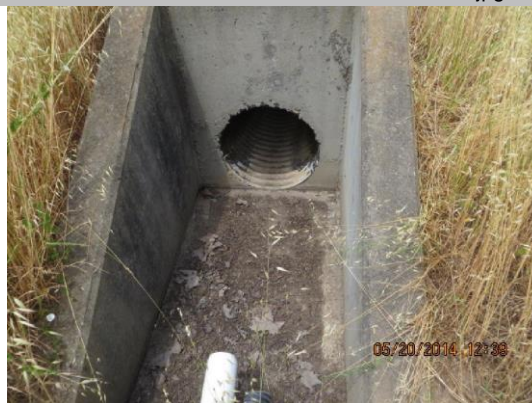
Photo 2 of 3 : UCIP\_FA\_2018\_38122\_69341.jpg

Headwall on LS toe.

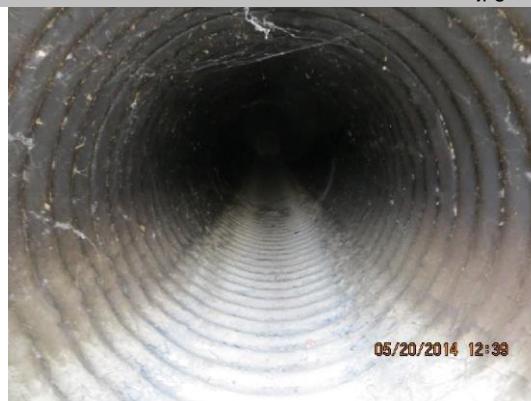
Photo 3 of 3 : UCIP\_FA\_2018\_38122\_69340.jpg

LM Start	15.62	Rating **	A/W	Issue No.	1204 (cont)	
LM End	15.62	Issue Type +	Ma	Location *		
Category	Supplemental			GPS Latitude/Longitude		
				Start		End
Item	DWR UCIP LMA Responsibility			38.129880 °		38.129880 °
				-121.158017 °		-121.158017 °
DWR ID	23784					
Comment Code						
Inspector Comment						
FS_ID:38122 DS_ID:23784 EP_NO: N/A Repair Type: No Action Needed Crossing Status: Found UCIP Comments: FIELD_STRUCT_DESC: 24-inch corrugated metal drainage pipe through the levee, 3 feet below the crown. Concrete U-shaped headwall on both ends. Flap gate on the waterside (WS) end. Cobble grouted spillway. Cobble grouted intake on the landside (LS). [Additional Reference(s): DWR Levee Log, 1990. USACE San Joaquin O&M Manual 612.2, 1967, (HLM 16.02)]. FS Date: 5/20/2014

Inside pipe at LS toe.

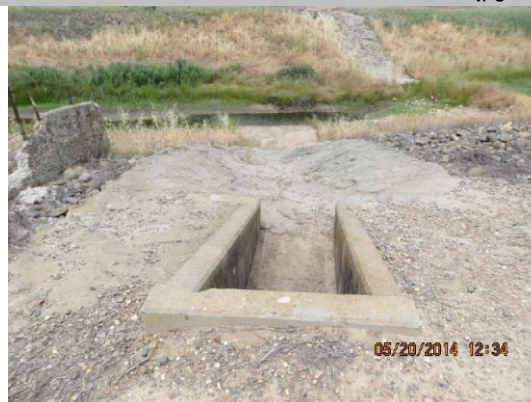
Photo 1 of 3 : UCIP\_FA\_2018\_38121\_69337.jpg

LM Start	15.75	Rating **	A/W	Issue No.	1205
LM End	15.75	Issue Type +	Ma	Location *	
Category	Supplemental			GPS Latitude/Longitude	
				Start	End
Item	DWR UCIP LMA Responsibility			38.129962 °	38.129962 °
				-121.155657 °	-121.155657 °
DWR ID	23785				
Comment Code					
Inspector Comment					
FS_ID:38121 DS_ID:23785 EP_NO: N/A Repair Type: No Action Needed Crossing Status: Found UCIP Comments: FIELD_STRUCT_DESC: 24-inch corrugated metal drainage pipe through the levee, 1.5 feet below the crown. Concrete U-shaped headwall on both ends. Flap gate on the waterside (WS) end. Cobble grouted spillway. Cobble grouted intake on the landside (LS). [Additional Reference(s): DWR Levee Log, 1990. USACE San Joaquin O&M Manual 612.2, 1967, (HLM 16.15)]. FS Date: 5/20/2014

Headwall, flapgate, and grouted spillway on WS slope.

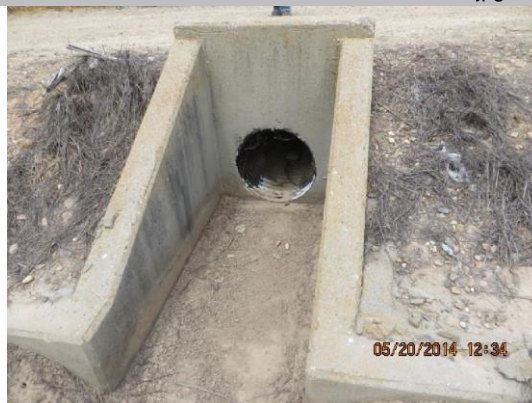
Photo 3 of 3 : UCIP\_FA\_2018\_38121\_69335.jpg

Headwall on LS toe.

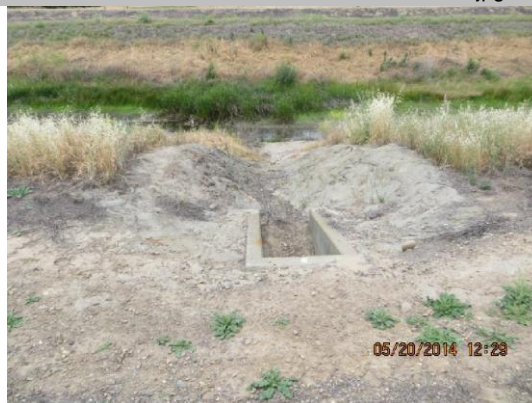
Photo 2 of 3 : UCIP\_FA\_2018\_38120\_69332.jpg

Headwall and flapgate at WS toe.

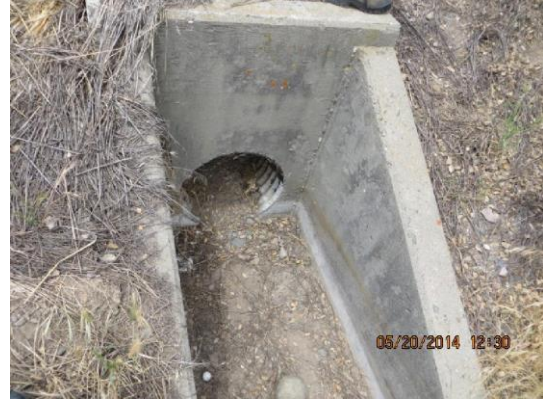
Photo 3 of 3 : UCIP\_FA\_2018\_38120\_69331.jpg

LM Start	15.82	Rating **	A/W	Issue No.	1206 (cont)	
LM End	15.82	Issue Type +	Ma	Location *		
Category	Supplemental			GPS Latitude/Longitude		
				Start	End	
Item	DWR UCIP LMA Responsibility			38.130425°	38.130425°	
				-121.154574°	-121.154574°	
DWR ID	23786					
Comment Code						
Inspector Comment						
FS_ID:38120 DS_ID:23786 EP_NO: N/A Repair Type: No Action Needed Crossing Status: Found UCIP Comments: FIELD_STRUCT_DESC: 24-inch corrugated metal drainage pipe through the levee, 8 feet below the crown. Concrete U-shaped headwall on both ends. Flap gate on the waterside (WS) end. Cobble grouted spillway. Cobble grouted intake on the landside (LS). [Additional Reference(s): DWR Levee Log, 1990. USACE San Joaquin O&M Manual 612.2, 1967, (HLM 16.22)]. FS Date: 5/20/2014

Headwall at LS toe.

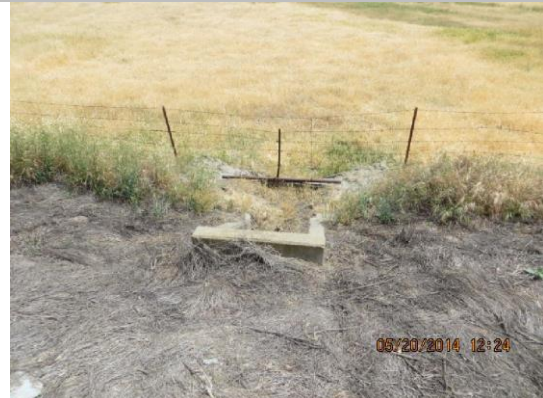
Photo 1 of 3 : UCIP\_FA\_2018\_38119\_69328.jpg

LM Start	15.88	Rating **	A/W	Issue No.	1207
LM End	15.88	Issue Type +	Ma	Location *	
Category	Supplemental			GPS Latitude/Longitude	
				Start	End
Item	DWR UCIP LMA Responsibility			38.131106°	38.131106°
				-121.153977°	-121.153977°
DWR ID	23787				
Comment Code					
Inspector Comment					
FS_ID:38119 DS_ID:23787 EP_NO: N/A Repair Type: No Action Needed Crossing Status: Found UCIP Comments: FIELD_STRUCT_DESC: 24-inch corrugated metal drainage pipe through the levee, 6 feet below the crown. Concrete U-shaped headwall on both ends. Flap gate on the waterside (WS) end. Cobble grouted spillway. Cobble grouted intake on the landside (LS). [Additional Reference(s): DWR Levee Log, 1990. USACE San Joaquin O&M Manual 612.2, 1967, (HLM 16.27)]. FS Date: 5/20/2014

Concrete headwall on LS toe.

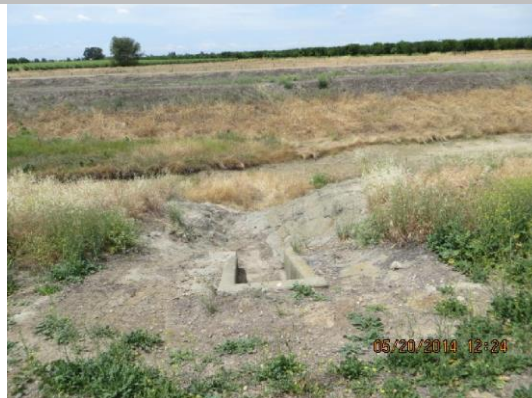
Photo 2 of 3 : UCIP\_FA\_2018\_38119\_69327.jpg

Flapgate and headwall on WS toe.

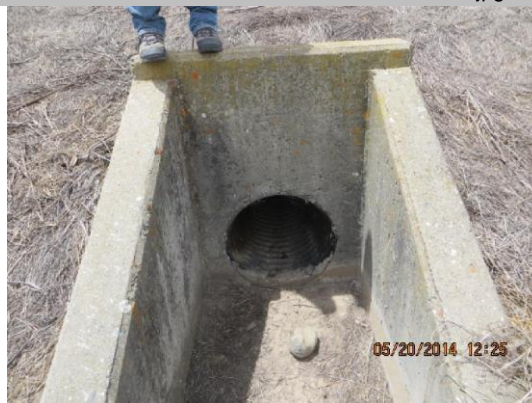
Photo 3 of 3 : UCIP\_FA\_2018\_38119\_69326.jpg

Concrete headwall on LS toe.

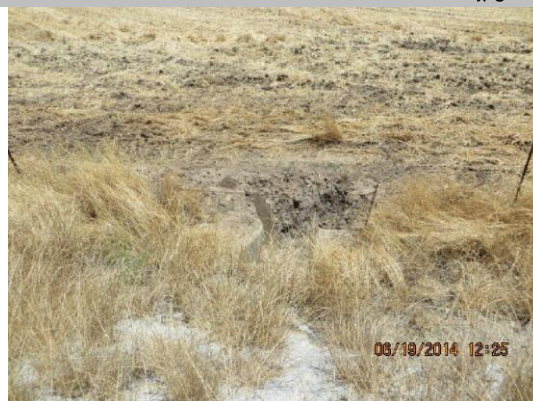
Photo 1 of 3 : UCIP\_FA\_2018\_38975\_71120.jpg

Comment Code						
Inspector Comment						
FS_ID:38975 DS_ID:23850 EP_NO: N/A Repair Type: No Action Needed Crossing Status: Found UCIP Comments: FIELD_STRUCT_DESC: 24-inch CM drainage pipe through the levee, 9.5-feet below the crown. Concrete "U" headwall on both ends. Flap gate on the waterward end. Cobble grouted spillway. Cobble grouted intake on the landward side. O&M Manual Bear Creek Part 2, 1967. Included in O&M Manual Bear Creek Addendum, February 1999. [Additional Reference(s): DWR Levee Log, 1977, 1978, 1987, 1990. USACE San Joaquin O&M Manual Unit 612, Part No. 2 - Bear Creel Project, Unit 7: HLM 7.19 – 16.77, Unit 8: HLM 7.55-16.48, Unit 9: HLM 0.10-1.52; Unit 10: HLM 0.03-1.35, Unit 11: HLM 0.16-3.55, Unit 12: HLM 0.14-3.91; Unit 13, HLM 0.03-1.18; Unit 14, HLM 0.02-1.17, 1967, (HLM 1.52)] FS Date: 6/19/2014

Pipe and headwall on LS toe.

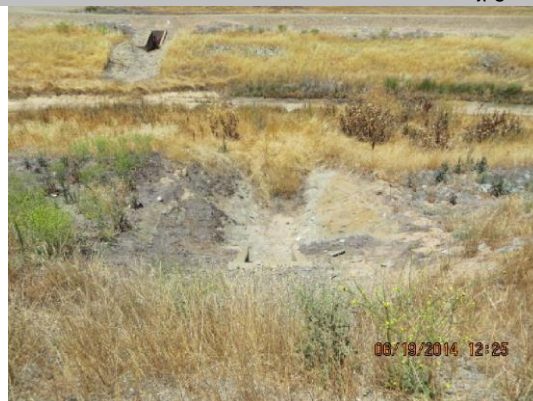
Photo 2 of 3 : UCIP\_FA\_2018\_38975\_71119.jpg

Pipe, flapgate, and grouted spillway on WS slope.

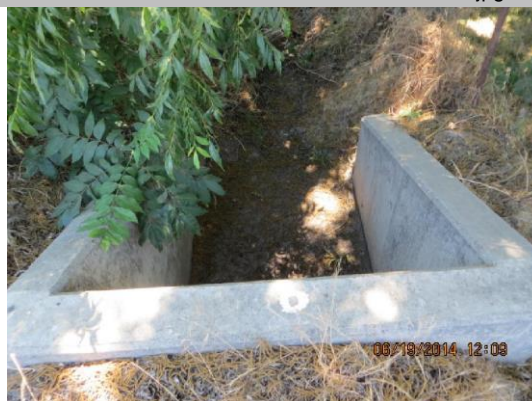
Photo 1 of 3 : UCIP\_FA\_2018\_38973\_71110.jpg

LM Start	0.55	Rating **	A/W	Issue No.	19	
LM End	0.55	Issue Type +	Ma	Location *		
Category	Supplemental			GPS Latitude/Longitude		
				Start		End
Item	DWR UCIP LMA Responsibility			38.094855 °		38.094855 °
				-121.166867 °		-121.166867 °
DWR ID	23853					
Comment Code						
Inspector Comment						
FS_ID:38973 DS_ID:23853 EP_NO: N/A Repair Type: No Action Needed Crossing Status: Found UCIP Comments: FIELD_STRUCT_DESC: 24-inch corrugated metal drainage pipe through the levee, 4.5 feet below the crown. Flap gate on the waterside (WS) end. Concrete U-shaped headwall on both ends. Cobble grouted spillway. Cobble grouted intake on the landside (LS). [Additional Reference(s): DWR Levee Log, 1987. USACE San Joaquin O&M Manual 612.2, 1967, (HLM 0.56)]. FS Date: 6/19/2014

Pipe and headwall on LS toe.

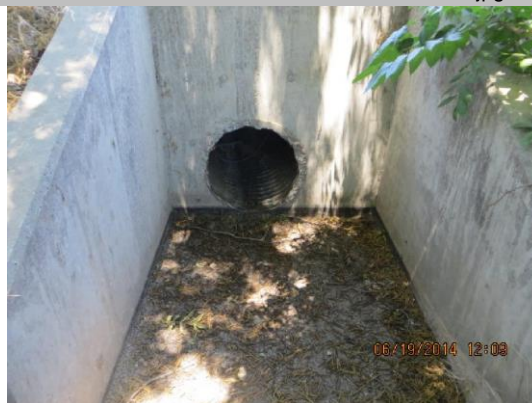
Photo 2 of 3 : UCIP\_FA\_2018\_38973\_71109.jpg

Pipe and headwall on LS toe.

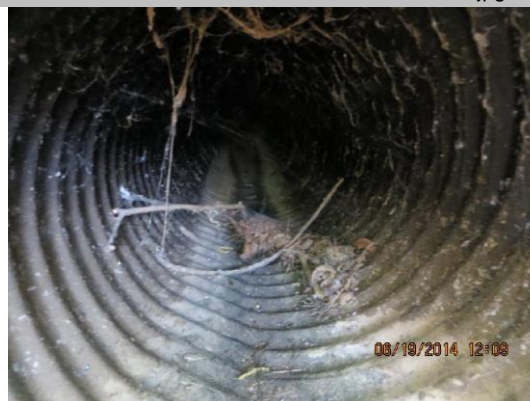
Photo 3 of 3 : UCIP\_FA\_2018\_38973\_71108.jpg

LM Start	0.55	Rating **	A/W	Issue No.	19 (cont)	
LM End	0.55	Issue Type +	Ma	Location *		
Category	Supplemental			GPS Latitude/Longitude		
				Start		End
Item	DWR UCIP LMA Responsibility			38.094855 °		38.094855 °
				-121.166867 °		-121.166867 °
DWR ID	23853					
Comment Code						
Inspector Comment						
FS_ID:38973 DS_ID:23853 EP_NO: N/A Repair Type: No Action Needed Crossing Status: Found UCIP Comments: FIELD_STRUCT_DESC: 24-inch corrugated metal drainage pipe through the levee, 4.5 feet below the crown. Flap gate on the waterside (WS) end. Concrete U-shaped headwall on both ends. Cobble grouted spillway. Cobble grouted intake on the landside (LS). [Additional Reference(s): DWR Levee Log, 1987. USACE San Joaquin O&M Manual 612.2, 1967, (HLM 0.56)]. FS Date: 6/19/2014

Inside pipe at LS toe.

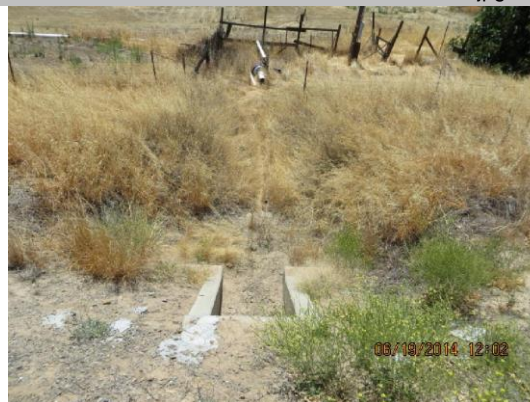
Photo 1 of 3 : UCIP\_FA\_2018\_38972\_71105.jpg

Comment Code					
Inspector Comment					
FS_ID:38972 DS_ID:23839 EP_NO: N/A Repair Type: No Action Needed Crossing Status: Found UCIP Comments: Suction hose and appurtances appear to be abandoned. FIELD_STRUCT_DESC: 24-inch corrugated metal drainage pipe through the levee, 8 feet below the crown. Concrete U-shaped headwall on both ends. Flap gate on the waterside (WS) end. Cobble grouted spillway. Cobble grouted intake on the landside (LS). Pump with suction hose sleeved through storm drainage pipe located on the LS, removed during winter months. (Suction hose sleeved through pipe under Permit No. 11530, 1976 - Constantine M. Coppulos). [Additional Reference(s): DWR Levee Log, 1987. USACE San Joaquin O&M Manual 612.2, 1967, (HLM 0.62) and 612 (addendum), February 1999, (HLM 0.61) (Station 32+46)]. FS Date: 6/19/2014

Pipe and headwall on LS toe.

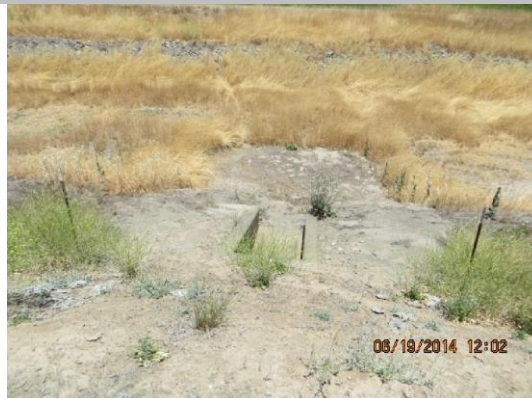
Photo 2 of 3 : UCIP\_FA\_2018\_38972\_71104.jpg

Pipe, flapgate, and grouted spillway on WS slope.

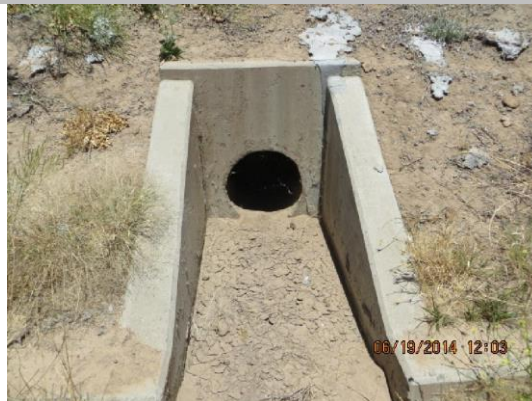
Photo 3 of 3 : UCIP\_FA\_2018\_38972\_71103.jpg

Pipe and headwall on LS toe.

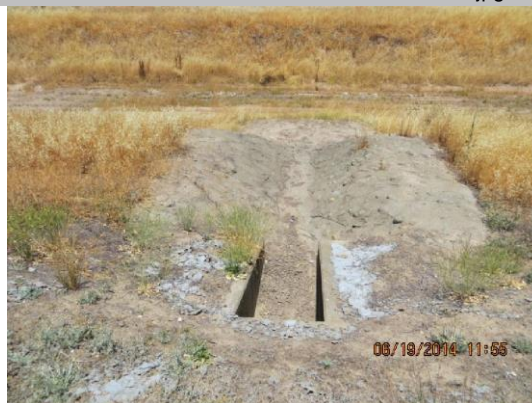
Photo 2 of 3 : UCIP\_FA\_2018\_38971\_71099.jpg

Pipe, flapgate, and grouted spillway on WS slope.

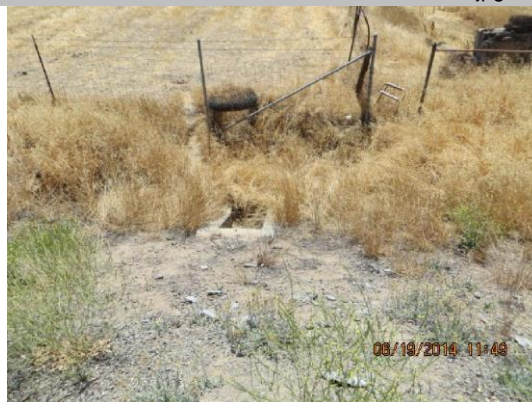
Photo 1 of 3 : UCIP\_FA\_2018\_41812\_71095.jpg

LM Start	0.93	Rating **	M	Issue No.	22
LM End	0.93	Issue Type +	Ma	Location *	
Category	Supplemental			GPS Latitude/Longitude	
				Start	End
Item	DWR UCIP LMA Responsibility			38.094247 °	38.094247 °
				-121.160271 °	-121.160271 °
DWR ID	23841				
Comment Code					
Inspector Comment					
FS_ID:41812					
DS_ID:23841					
EP_NO: N/A					
Repair Type: Non-Urgent					
Crossing Status: Found					
UCIP Comments: Sediment buildup inside pipe.					
FIELD_STRUCT_DESC: 12-inch corrugated metal storm drainage pipe through the levee, 7 feet below the crown. Headwall on the landside (LS) toe. Flap gate on the waterside (WS) end. Cobble grouted spillway. [Additional Reference(s): DWR Levee Log, 1987. USACE San Joaquin O&M Manual 612 (addendum), February 1999, (HLM 0.93) (Station 49+30)].					
FS Date: 6/19/2014

Pipe and headwall on LS toe.

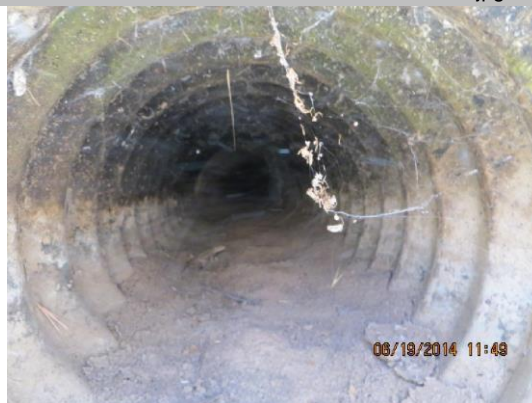
Photo 3 of 3 : UCIP\_FA\_2018\_41812\_71093.jpg

Inside pipe at LS toe.

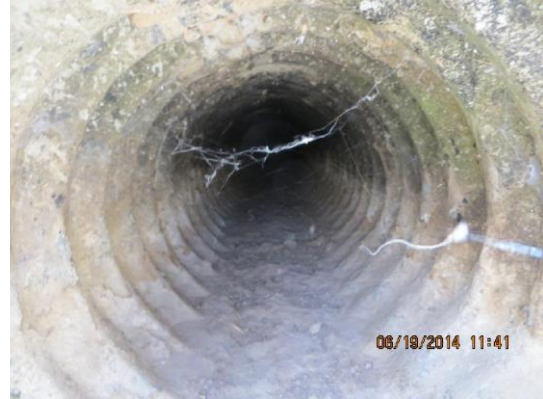
Photo 3 of 3 : UCIP\_FA\_2018\_38969\_71088.jpg

Inside pipe at LS toe.

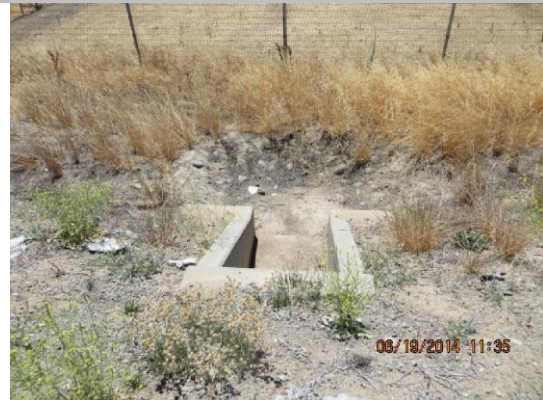
Photo 1 of 3 : UCIP\_FA\_2018\_38968\_71085.jpg

Headwall at LS toe.
