**Flood Control Project Maintenance  
Levee Inspections**

**Maintenance Issue Types Only, Levee Inspection Report By Mile - Fall 2018**

**San Joaquin County Flood Control and Water Conservation District**

Waterway	Bank	Unit Miles	Inspection Start/End	Inspector
Unit No. 01 Littlejohn Creek	Left	2.59	10/18/2018 10/18/2018	Wade Wylie

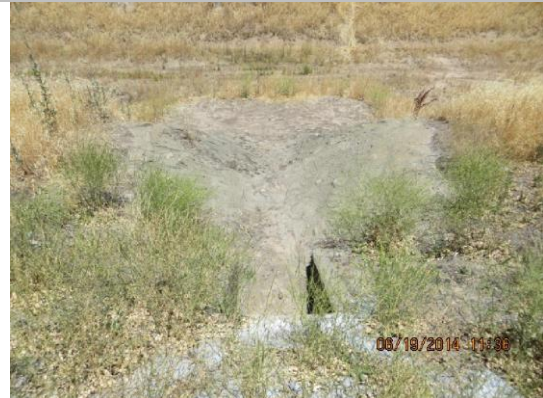
Photo 2 of 3 : UCIP\_FA\_2018\_38968\_71084.jpg

Pipe, flapgate, and grouted spillway on WS toe.

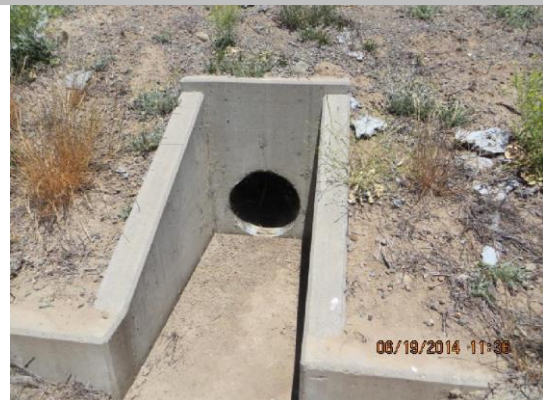
Photo 3 of 3 : UCIP\_FA\_2018\_38968\_71083.jpg

Headwall at LS toe.

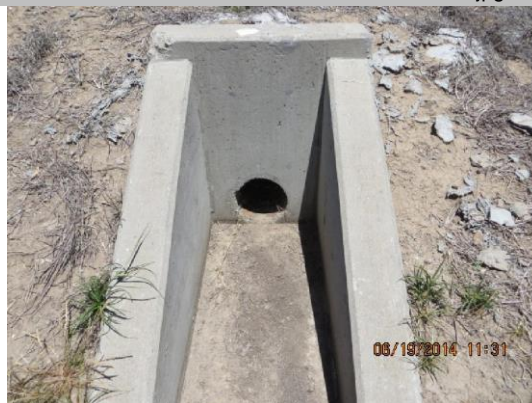
Photo 2 of 3 : UCIP\_FA\_2018\_38967\_71078.jpg

Pipe and headwall on LS toe.

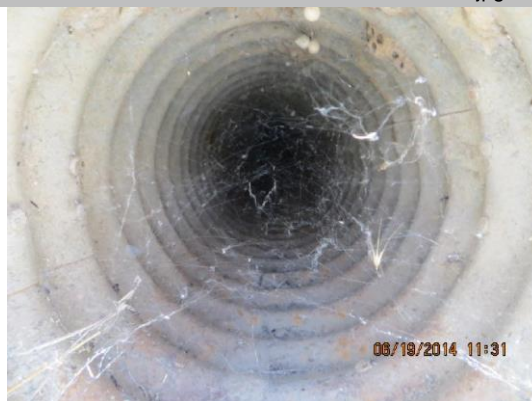
Photo 3 of 3 : UCIP\_FA\_2018\_38967\_71082.jpg

Inside pipe at LS toe.

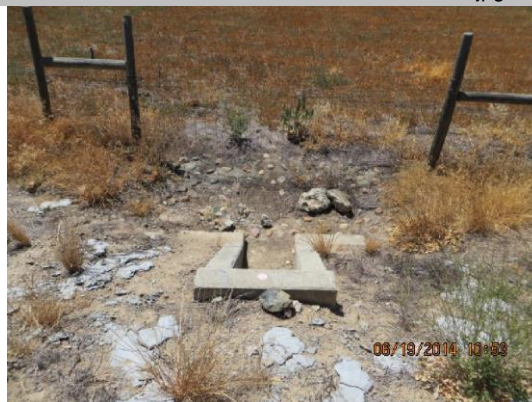
Photo 1 of 3 : UCIP\_FA\_2018\_38997\_71074.jpg

Headwall at LS toe.

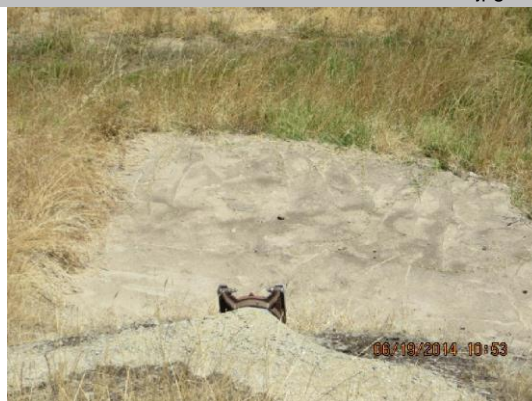
Photo 2 of 3 : UCIP\_FA\_2018\_38997\_71073.jpg

Pipe, flapgate, and grouted spillway on WS toe.

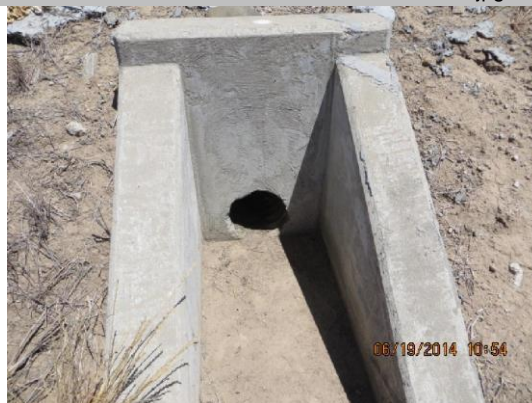
Photo 3 of 3 : UCIP\_FA\_2018\_38997\_71077.jpg

Headwall on LS toe.

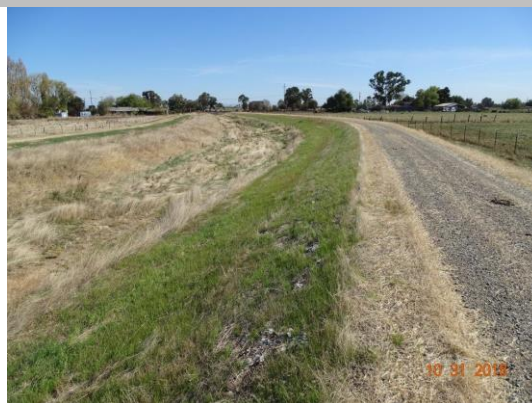
Photo 1 of 1 : FA\_2018\_NA0017\_153\_15\_20181105\_00037.jpg

LM Start	1.27	Rating **	A	Issue No.	15
LM End	1.27	Issue Type +	Ma	Location *	WS
Category	Earthen Levee			GPS Latitude/Longitude	
				Start	End
Item	Vegetation			38.094168 °	38.094168 °
				-121.153965 °	-121.153965 °
DWR ID	DWR_NA0017_09_f_2018_15				
Comment Code					
V1 : Control annual grass and weeds on the levee slopes and easements.					
Inspector Comment					
LMA maintains the vegetation at a high level.

View of the maintained waterside slope. Fall 2018.

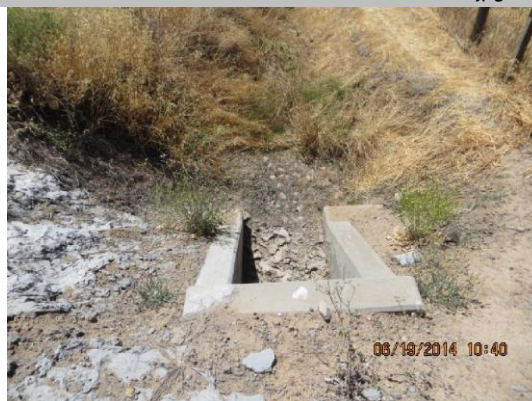
Photo 1 of 3 : UCIP\_FA\_2018\_38977\_71064.jpg

LM Start	1.44	Rating **	M	Issue No.	27
LM End	1.44	Issue Type +	Ma	Location *	
Category	Supplemental			GPS Latitude/Longitude	
				Start	End
Item	DWR UCIP LMA Responsibility			38.094073 °	38.094073 °
				-121.150947 °	-121.150947 °
DWR ID	23847				
Comment Code					
Inspector Comment					
FS_ID:38977					
DS_ID:23847					
EP_NO: N/A					
Repair Type: Non-Urgent					
Crossing Status: Found					
UCIP Comments: Flapgate blocked by soil and possibly concrete on WS slope.					
FIELD_STRUCT_DESC: 21-inch corrugated metal drainage pipe through the levee, 5.5 feet below the crown. Flap gate on the waterside (WS) end. Cobble grouted spillway. [Additional Reference(s): DWR Levee Log, 1987. USACE San Joaquin O&M Manual 612.2, 1967, (HLM 1.45) and 612 (addendum), February 1999, (HLM 1.45) (Station 76+42)].					
FS Date: 6/19/2014

Concrete headwall on LS toe.

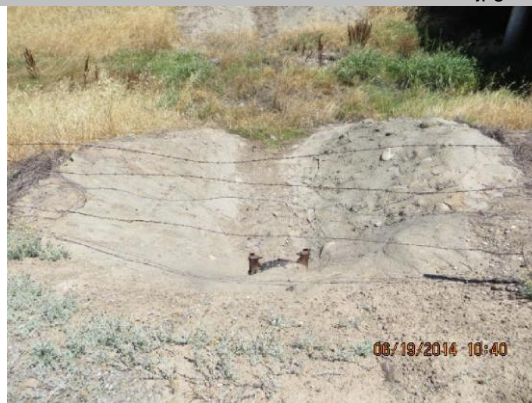
Photo 2 of 3 : UCIP\_FA\_2018\_38977\_71063.jpg

Pipe, flapgate, and grouted spillway on WS toe.

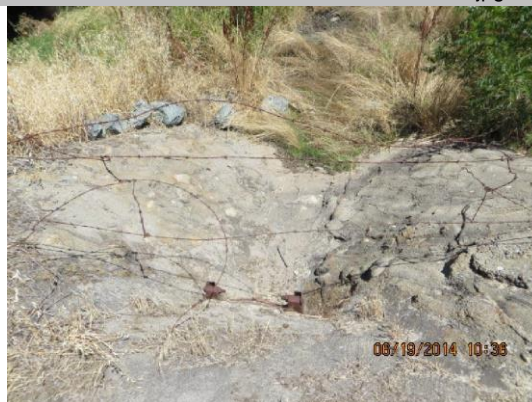
Photo 1 of 3 : UCIP\_FA\_2018\_38963\_71061.jpg

Pipe and flapgate on WS slope.

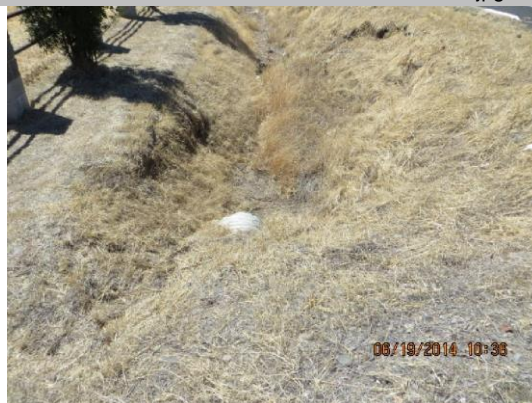
Photo 3 of 3 : UCIP\_FA\_2018\_38963\_71060.jpg

Pipe visible on LS toe.

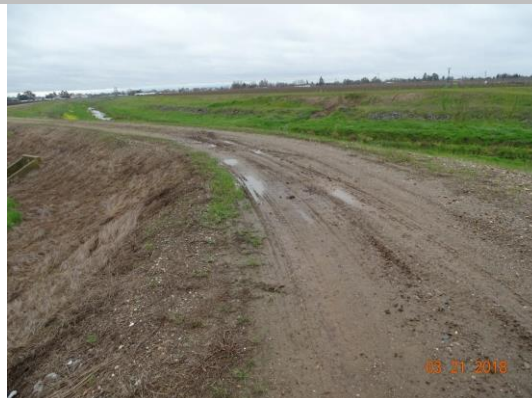
Photo 1 of 1 : FA\_2018\_NA0017\_154\_13\_20180926\_00005.jpg

LM Start	0.01	Rating **	M	Issue No.	13
LM End	0.02	Issue Type +	Ma	Location *	CR
Category	Earthen Levee			GPS Latitude/Longitude	
				Start	End
Item	Crown Surface / Depressions / Rutting			38.094151°	38.094141°
				-121.175869°	-121.175706°
DWR ID	DWR_NA0017_10_s_2018_13				
Comment Code					
C2 : Repair depressions or ruts in the crown or slope.					
Inspector Comment

Crown rutting looking east.

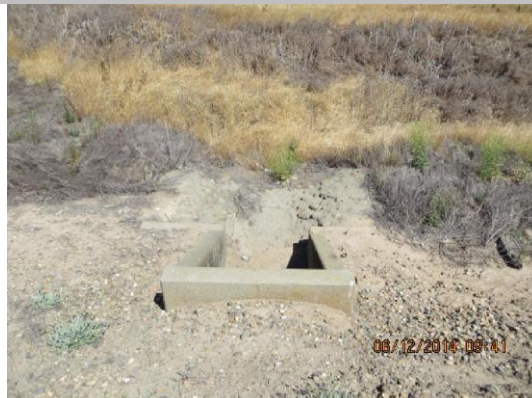
Photo 2 of 3 : UCIP\_FA\_2018\_38567\_70660.jpg

Headwall at LS toe.

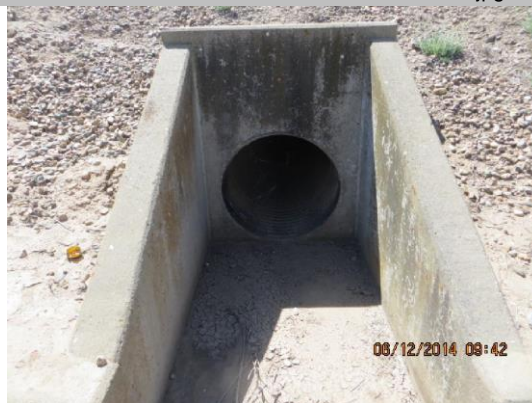
Photo 3 of 3 : UCIP\_FA\_2018\_38567\_70659.jpg

Headwall at LS toe.

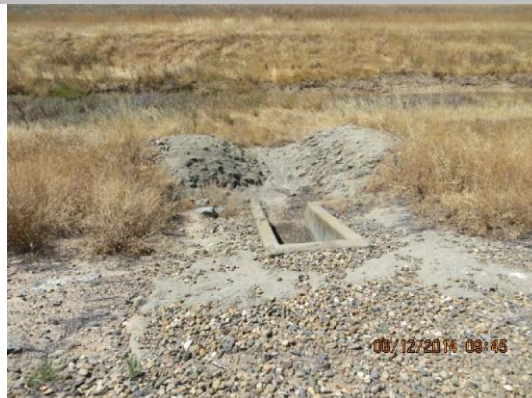
Photo 1 of 3 : UCIP\_FA\_2018\_38568\_70666.jpg

Headwall, flapgate, and grouted spillway on WS slope.

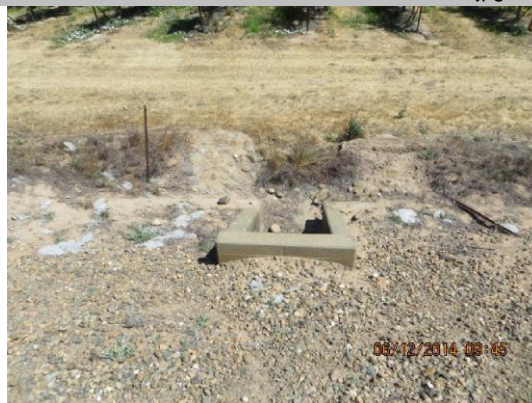
Photo 2 of 3 : UCIP\_FA\_2018\_38568\_70665.jpg

Headwall at LS toe.

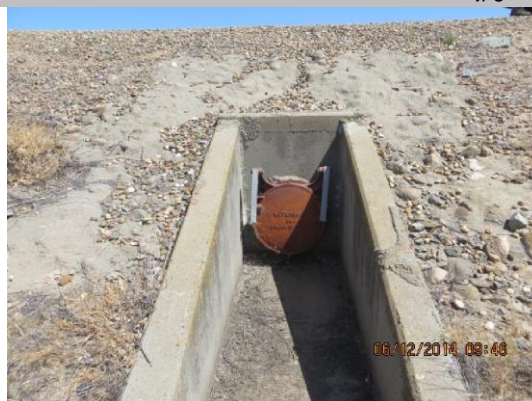
Photo 3 of 3 : UCIP\_FA\_2018\_38568\_70664.jpg

Headwall and flapgate on WS slope.

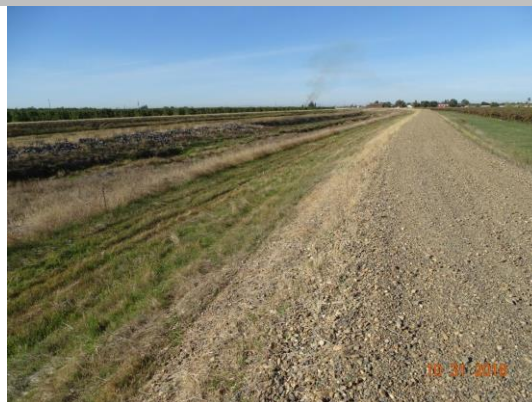
Photo 1 of 1 : FA\_2018\_NA0017\_154\_14\_20181105\_00033.jpg

LM Start	0.33	Rating **	A	Issue No.	14
LM End	0.33	Issue Type +	Ma	Location *	WS
Category	Earthen Levee			GPS Latitude/Longitude	
				Start	End
Item	Vegetation			38.094986 °	38.094986 °
				-121.170150 °	-121.170150 °
DWR ID	DWR_NA0017_10_f_2018_14				
Comment Code					
V1 : Control annual grass and weeds on the levee slopes and easements.					
Inspector Comment					
The LMA maintains the vegetation at a high level.

View of maintained waterside slope. Fall 2018.

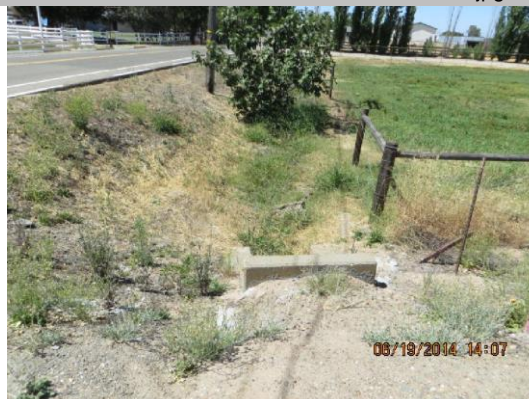
Photo 1 of 3 : UCIP\_FA\_2018\_38992\_71158.jpg

Pipe and headwall on LS toe.

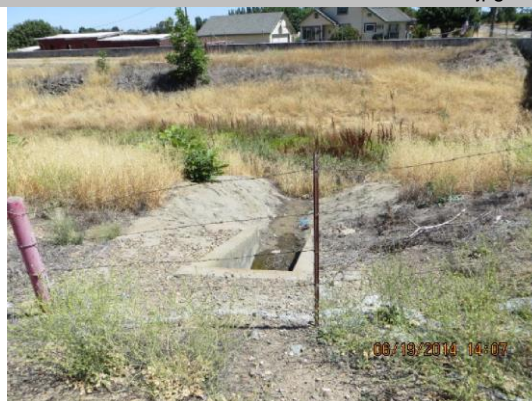
Photo 2 of 3 : UCIP\_FA\_2018\_38992\_71157.jpg

Pipe, headwall, flapgate, and grouted spillway on WS toe.

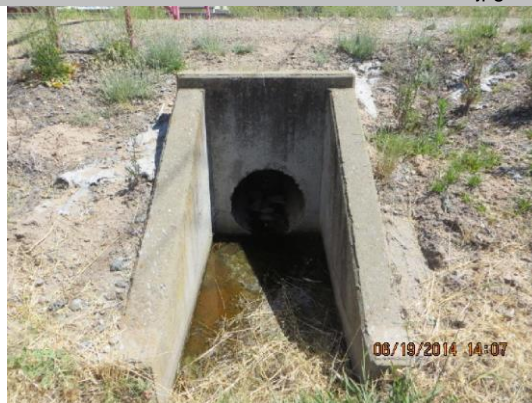
Photo 3 of 3 : UCIP\_FA\_2018\_38992\_71156.jpg

Pipe and headwall on LS toe.

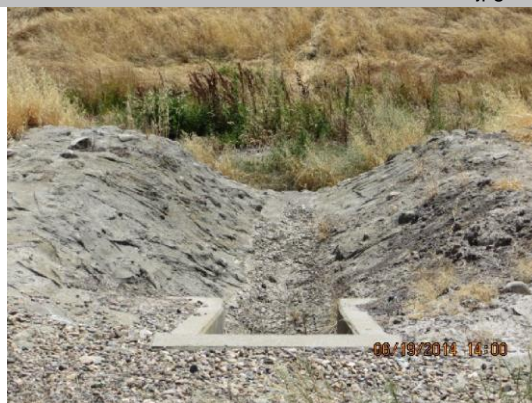
Photo 1 of 3 : UCIP\_FA\_2018\_38990\_71153.jpg

Pipe, headwall, flapgate, and grouted spillway on WS toe.

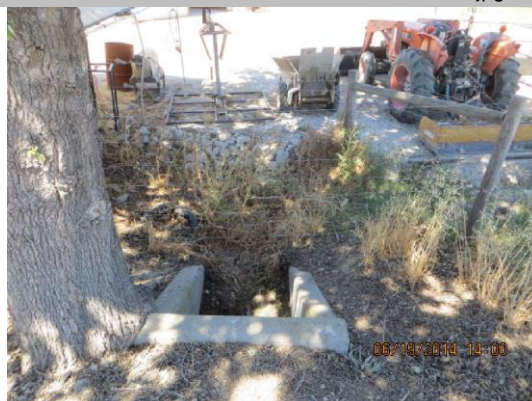
Photo 2 of 3 : UCIP\_FA\_2018\_38990\_71152.jpg

Pipe and headwall on LS toe.

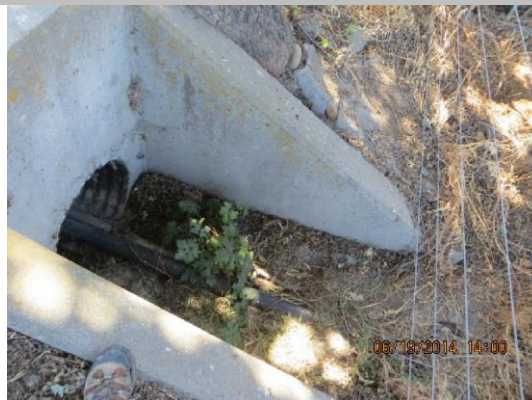
Photo 3 of 3 : UCIP\_FA\_2018\_38990\_71151.jpg

Pipe and headwall on LS toe.

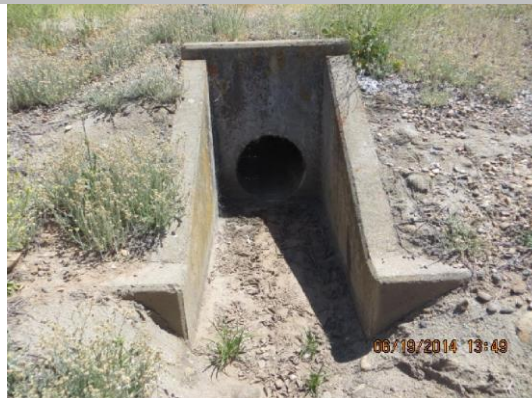
Photo 2 of 3 : UCIP\_FA\_2018\_38988\_71143.jpg

Pipe and headwall on LS toe.

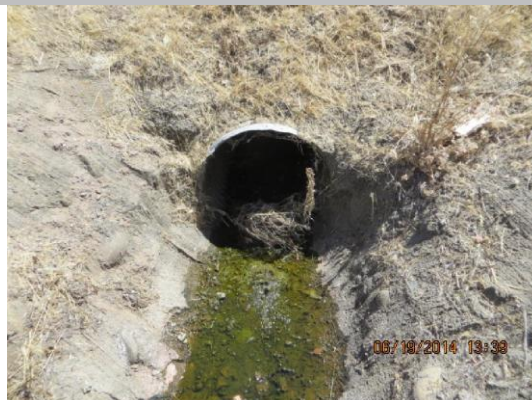
Photo 3 of 3 : UCIP\_FA\_2018\_51721\_71132.jpg

Pipe on LS toe.

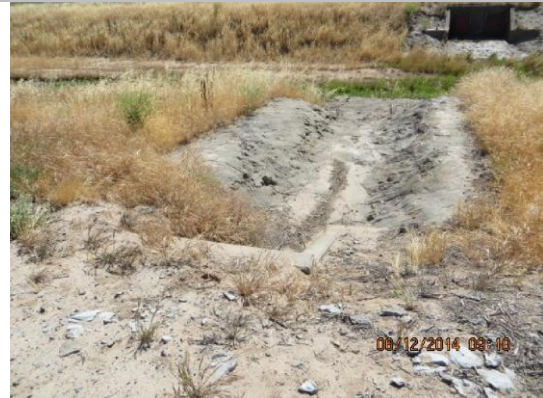
Photo 1 of 3 : UCIP\_FA\_2018\_38566\_70656.jpg

Headwall, flapgate, and grouted spillway on WS slope.

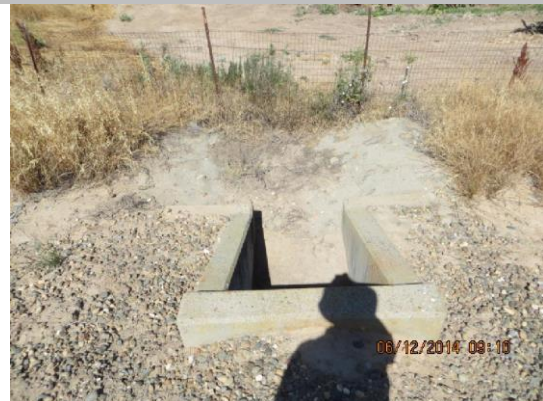
Photo 2 of 3 : UCIP\_FA\_2018\_38566\_70655.jpg

Headwall at LS toe.

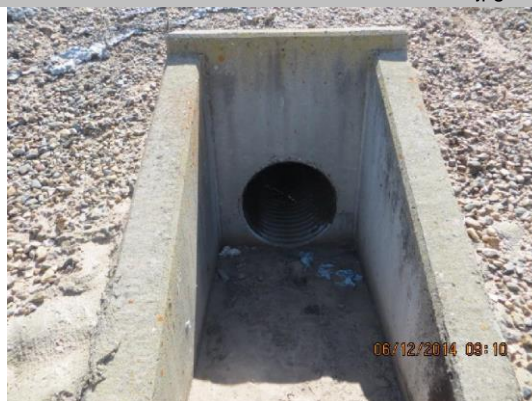
Photo 3 of 3 : UCIP\_FA\_2018\_38566\_70654.jpg

Headwall at LS toe.

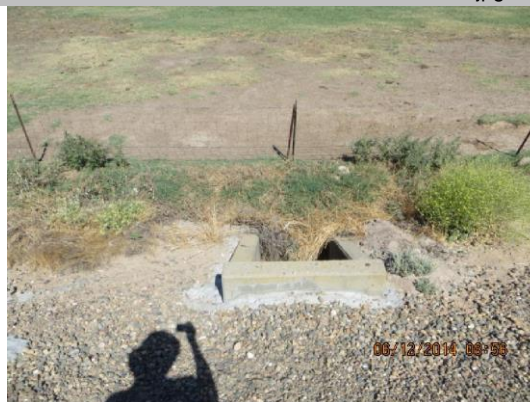
Photo 1 of 3 : UCIP\_FA\_2018\_38565\_70651.jpg

Headwall at LS toe.

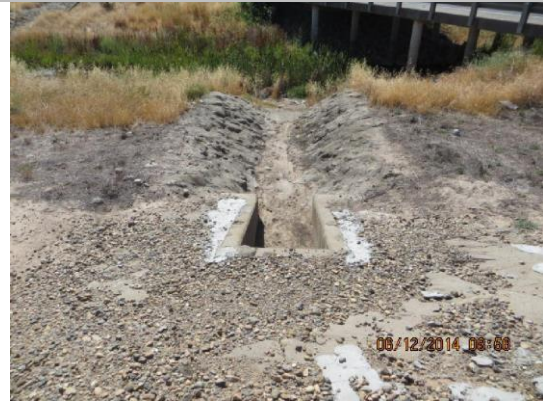
Photo 2 of 3 : UCIP\_FA\_2018\_38565\_70650.jpg

Headwall, flapgate, and grouted spillway on WS slope.

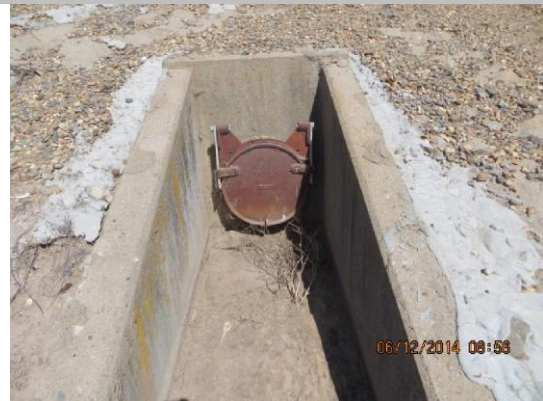
Photo 3 of 3 : UCIP\_FA\_2018\_38565\_70649.jpg

Headwall and flapgate on WS slope.

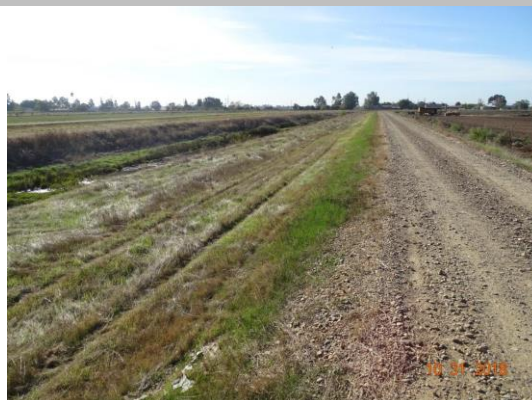
Photo 1 of 1 : FA\_2018\_NA0017\_155\_41\_20181105\_00098.jpg

LM Start	0.79	Rating **	A	Issue No.	41
LM End	0.79	Issue Type +	Ma	Location *	WS
Category	Earthen Levee			GPS Latitude/Longitude	
				Start	End
Item	Vegetation			38.105195 °	38.105195 °
				-121.166252 °	-121.166252 °
DWR ID	DWR_NA0017_11_f_2018_41				
Comment Code					
V1 : Control annual grass and weeds on the levee slopes and easements.					
Inspector Comment					
LMA maintains the vegetation at a high level.

View of maintained waterside slope. Fall 2018.

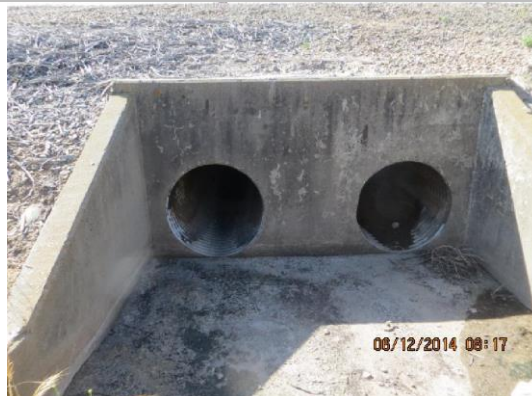
Photo 3 of 3 : UCIP\_FA\_2018\_38557\_70611.jpg

Headwall at LS toe.

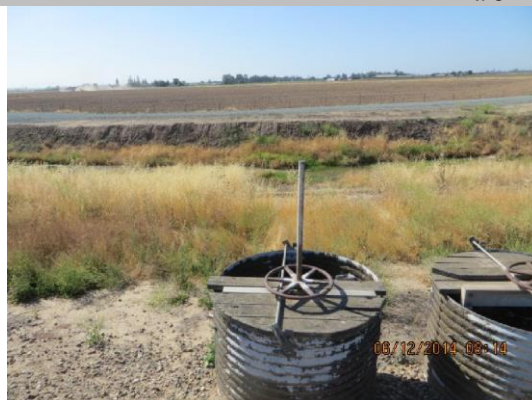
Photo 1 of 3 : UCIP\_FA\_2018\_38556\_70608.jpg

Comment Code						
Inspector Comment						
FS_ID:38556						
DS_ID:23897						
EP_NO: N/A						
Repair Type: Non-Urgent						
Crossing Status: Found						
UCIP Comments: Slidegate not functional or rusted in place. No lid on						
CMP riser at WS slope.						
FIELD_STRUCT_DESC: 2 of 2: 36-inch corrugated metal drainage pipe						
through the levee, 7 feet below the crown. Slide gate in 48-inch						
corrugated metal riser unit on the waterside (WS) slope. Concrete U-						
shaped headwall on both ends. Flap gate on the WS end. Cobble						
grouted spillway. Cobble grouted intake on the landside (LS).						
[Additional Reference(s): DWR Levee Log, 1978. USACE San Joaquin						
O&M Manual 612.2, 1967, (HLM 1.51)].						
FS Date: 6/12/2014

Slidegate in CMP riser on WS shoulder. No lid and gateavale does not work.

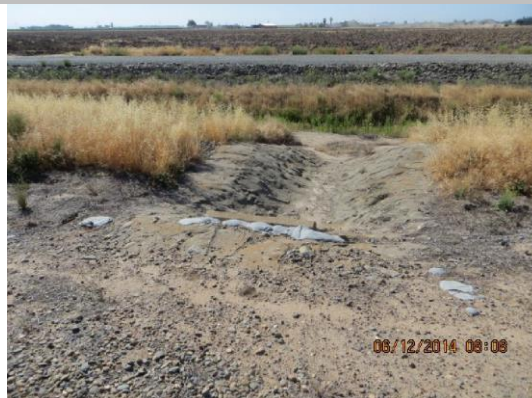
Photo 1 of 3 : UCIP\_FA\_2018\_38555\_70603.jpg

LM Start	1.81	Rating **	A/W	Issue No.	216
LM End	1.81	Issue Type +	Ma	Location *	
Category	Supplemental			GPS Latitude/Longitude	
				Start	End
Item	DWR UCIP LMA Responsibility			38.114551°	38.114551°
				-121.156224°	-121.156224°
DWR ID	23872				
Comment Code					
Inspector Comment					
FS_ID:38555 DS_ID:23872 EP_NO: N/A Repair Type: No Action Needed Crossing Status: Found UCIP Comments: FIELD_STRUCT_DESC: 24-inch corrugated metal drainage pipe through the levee, 5.5 feet below the crown. Concrete U-shaped headwall on both ends. Flap gate on the waterside (WS) end. Cobble grouted spillway. Cobble grouted intake on the landside (LS). [Additional Reference(s): DWR Levee Log, 1978. USACE San Joaquin O&M Manual 612.2, 1967, (HLM 1.82)]. FS Date: 6/12/2014

Headwall, flapgate, and grouted spillway on WS slope.

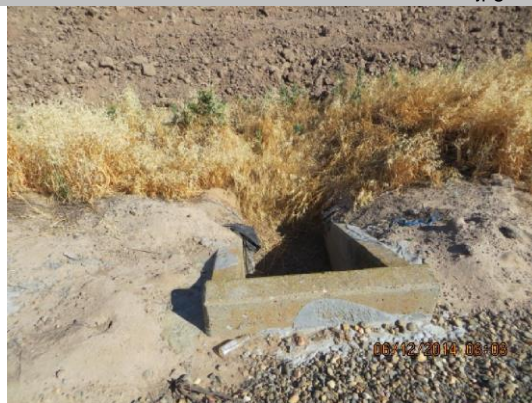
Photo 2 of 3 : UCIP\_FA\_2018\_38555\_70602.jpg

Headwall at LS toe.

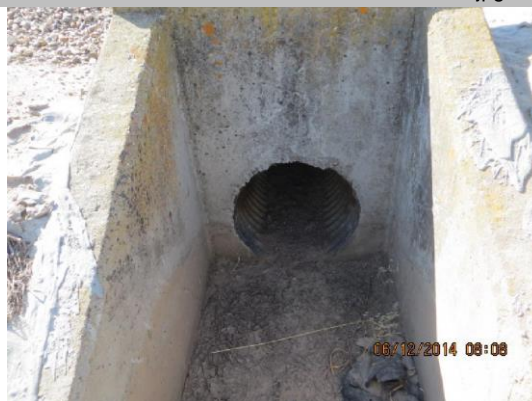
Photo 3 of 3 : UCIP\_FA\_2018\_38555\_70601.jpg

Headwall at LS toe.

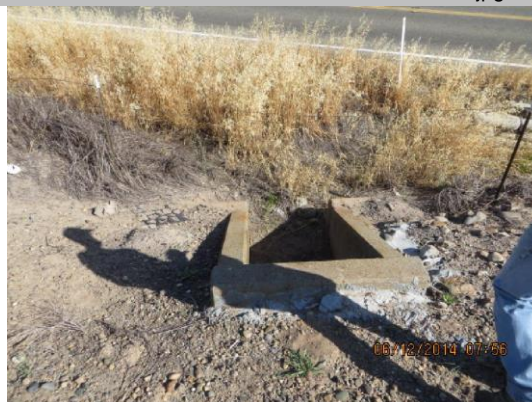
Photo 1 of 3 : UCIP\_FA\_2018\_38552\_70590.jpg

LM Start	2.04	Rating **	A/W	Issue No.	218	
LM End	2.04	Issue Type +	Ma	Location *		
Category	Supplemental			GPS Latitude/Longitude		
				Start		End
Item	DWR UCIP LMA Responsibility			38.117176 °		38.117176 °
				-121.154019 °		-121.154019 °
DWR ID	23874					
Comment Code						
Inspector Comment						
FS_ID:38552 DS_ID:23874 EP_NO: N/A Repair Type: No Action Needed Crossing Status: Found UCIP Comments: FIELD_STRUCT_DESC: 24-inch corrugated metal drainage pipe through the levee, 6 feet below the crown. Concrete U-shaped headwall on both ends. Flap gate on the waterside (WS) end. Cobble grouted spillway. Cobble grouted intake on the landside (LS). [Additional Reference(s): DWR Levee Log, 1978. USACE San Joaquin O&M Manual 612.2, 1967, (HLM 2.05)]. FS Date: 6/12/2014

Headwall at LS toe.

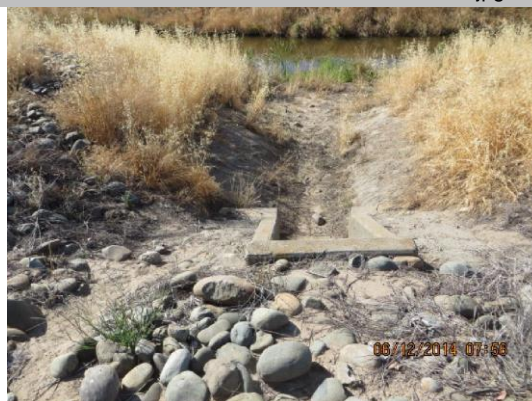
Photo 2 of 3 : UCIP\_FA\_2018\_38552\_70589.jpg

Headwall, flapgate, and grouted spillway on WS slope.

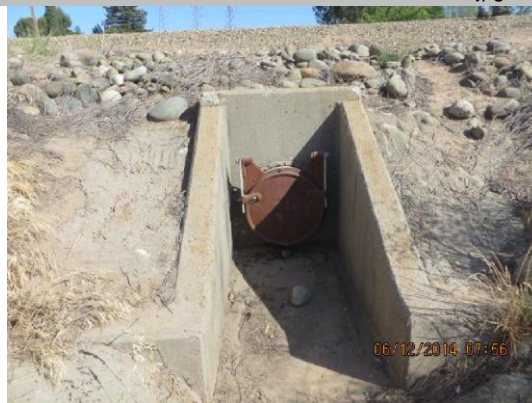
Photo 3 of 3 : UCIP\_FA\_2018\_38552\_70588.jpg

Headwall and flapgate on WS slope.

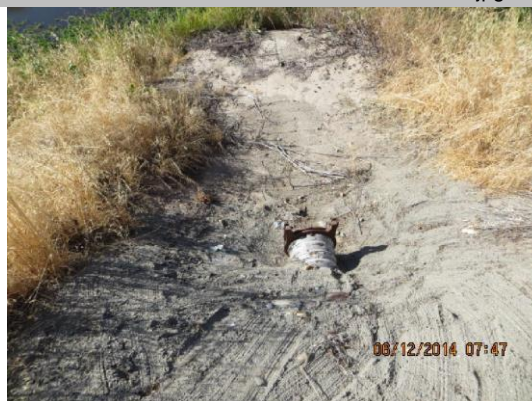
Photo 1 of 3 : UCIP\_FA\_2018\_38551\_70586.jpg

LM Start	2.12	Rating **	A/W	Issue No.	219
LM End	2.12	Issue Type +	Ma	Location *	
Category	Supplemental			GPS Latitude/Longitude	
				Start	End
Item	DWR UCIP LMA Responsibility			38.117580°	38.117580°
				-121.152490°	-121.152490°
DWR ID	23875				
Comment Code					
Inspector Comment					
FS_ID:38551					
DS_ID:23875					
EP_NO: N/A					
Repair Type: No Action Needed					
Crossing Status: Found					
UCIP Comments:					
FIELD_STRUCT_DESC: 12-inch corrugated metal drainage pipe					
through the levee, 5.5 feet below the crown. Flap gate on the waterside					
(WS) end. Drop inlet with grate at the landside (LS) toe. Spillway cobble					
grouted. [Additional Reference(s): DWR Levee Log, 1978. USACE San					
Joaquin O&M Manual 612.2, 1967, (HLM 2.14)].					
FS Date: 6/12/2014

Grouted outlet showing pipe and flapgate on WS slope.

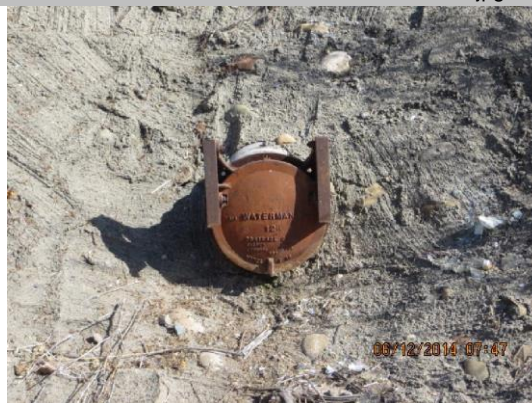
Photo 2 of 3 : UCIP\_FA\_2018\_38551\_70585.jpg

Grouted outlet showing pipe and flapgate on WS slope.

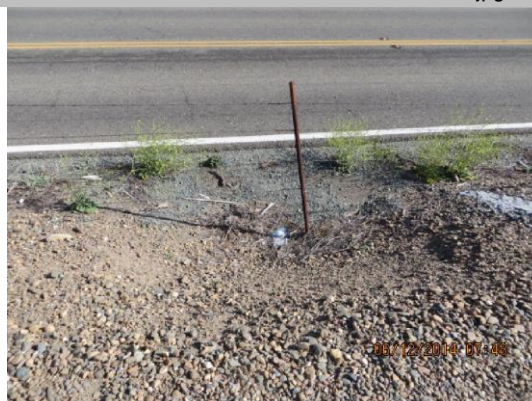
Photo 3 of 3 : UCIP\_FA\_2018\_38551\_70584.jpg

Grate over drop-inlet at LS toe next to T-post.

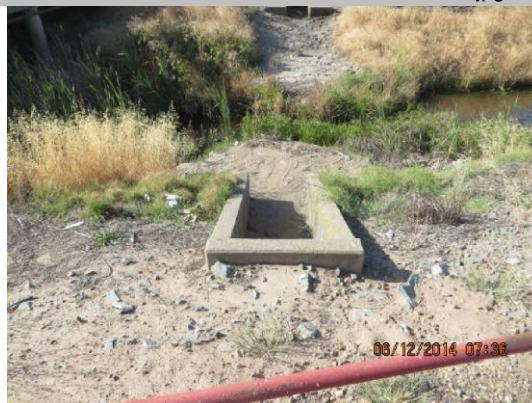
Photo 1 of 3 : UCIP\_FA\_2018\_38550\_70583.jpg

LM Start	2.20	Rating **	M	Issue No.	220
LM End	2.20	Issue Type +	Ma	Location *	
Category	Supplemental			GPS Latitude/Longitude	
				Start	End
Item	DWR UCIP LMA Responsibility			38.117920 °	38.117920 °
				-121.151120 °	-121.151120 °
DWR ID	23876				
Comment Code					
Inspector Comment					
FS_ID:38550 DS_ID:23876 EP_NO: N/A Repair Type: Non-Urgent Crossing Status: Found UCIP Comments: Concrete inlet at LS of East Kettleman road is damaged...may or may not be a hazard. FIELD_STRUCT_DESC: 24-inch corrugated metal drainage pipe through the levee, 5 feet below the crown. Concrete U-shaped headwall on the waterside (WS) end. Flap gate on the WS end. Cobble grouted spillway. 36-inch concrete catch basin on the landside (LS) end. [Additional Reference(s): DWR Levee Log, 1978. USACE San Joaquin O&M Manual 612.2, 1967, (HLM 2.22)]. FS Date: 6/12/2014

Headwall, flapgate, and grouted spillway on WS slope.

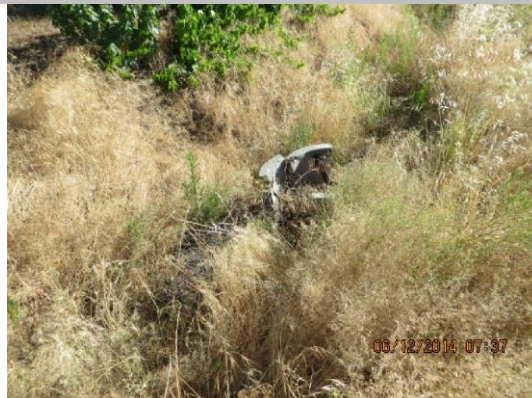
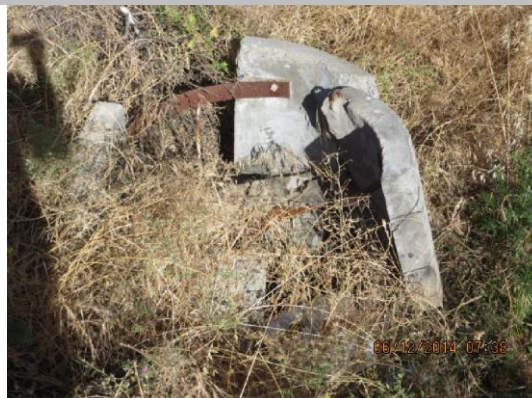
LM Start	2.20	Rating **	M	Issue No.	220 (cont)	
LM End	2.20	Issue Type +	Ma	Location *		
Category	Supplemental			GPS Latitude/Longitude		
				Start		End
Item	DWR UCIP LMA Responsibility			38.117920 °		38.117920 °
				-121.151120 °		-121.151120 °
DWR ID	23876					
Comment Code						
Inspector Comment						
FS_ID:38550 DS_ID:23876 EP_NO: N/A Repair Type: Non-Urgent Crossing Status: Found UCIP Comments: Concrete inlet at LS of East Kettleman road is damaged...may or may not be a hazard. FIELD_STRUCT_DESC: 24-inch corrugated metal drainage pipe through the levee, 5 feet below the crown. Concrete U-shaped headwall on the waterside (WS) end. Flap gate on the WS end. Cobble grouted spillway. 36-inch concrete catch basin on the landside (LS) end. [Additional Reference(s): DWR Levee Log, 1978. USACE San Joaquin O&M Manual 612.2, 1967, (HLM 2.22)]. FS Date: 6/12/2014

Concrete drop-inlet on North side of East Kettleman road damaged.

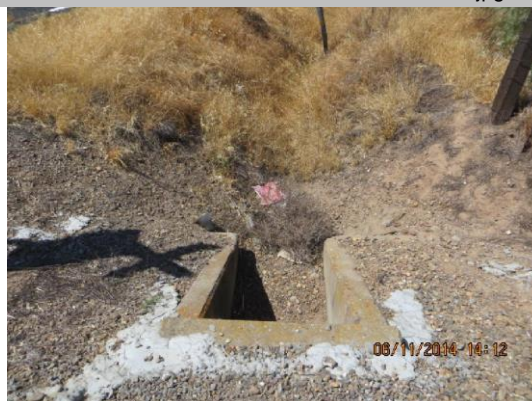
Photo 1 of 3 : UCIP\_FA\_2018\_38548\_70576.jpg

LM Start	2.22	Rating **	A/W	Issue No.	223
LM End	2.22	Issue Type +	Ma	Location *	
Category	Supplemental			GPS Latitude/Longitude	
				Start	End
Item	DWR UCIP LMA Responsibility			38.118083 °	38.118083 °
				-121.150782 °	-121.150782 °
DWR ID	23878				
Comment Code					
Inspector Comment					
FS_ID:38548 DS_ID:23878 EP_NO: N/A Repair Type: No Action Needed Crossing Status: Found UCIP Comments: FIELD_STRUCT_DESC: 24-inch corrugated metal drainage pipe through the levee, 5 feet below the crown. Concrete U-shaped headwall on both ends. Flap gate on the waterside (WS) end. Cobble grouted spillway. Cobble grouted intake on the landside (LS). [Additional Reference(s): DWR Levee Log, 1978. USACE San Joaquin O&M Manual 612.2, 1967, (HLM 2.24)]. FS Date: 6/11/2014

Headwall at LS toe.

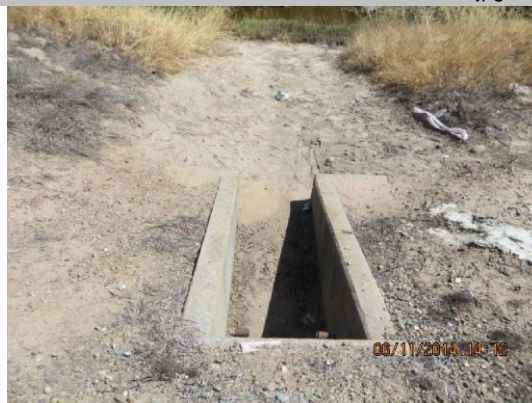
Photo 2 of 3 : UCIP\_FA\_2018\_38548\_70575.jpg

Headwall, flapgate, and grouted spillway on WS slope.

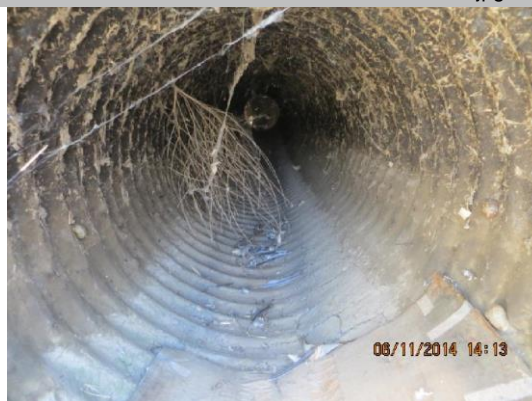
Photo 3 of 3 : UCIP\_FA\_2018\_38548\_70574.jpg

Inside pipe at LS toe.

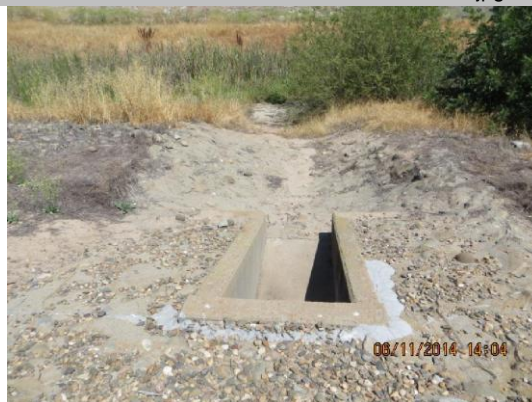
Photo 1 of 3 : UCIP\_FA\_2018\_38546\_70571.jpg

LM Start	2.43	Rating **	A/W	Issue No.	224
LM End	2.43	Issue Type +	Ma	Location *	
Category	Supplemental			GPS Latitude/Longitude	
				Start	End
Item	DWR UCIP LMA Responsibility			38.119587 °	38.119587 °
				-121.147961 °	-121.147961 °
DWR ID	23886				
Comment Code					
Inspector Comment					
FS_ID:38546 DS_ID:23886 EP_NO: N/A Repair Type: No Action Needed Crossing Status: Found UCIP Comments: FIELD_STRUCT_DESC: 24-inch corrugated metal drainage pipe through the levee, 4.5 feet below the crown. Concrete U-shaped headwall on both ends. Flap gate on the waterside (WS) end. Cobble grouted spillway. Cobble grouted intake on the landside (LS). [Additional Reference(s): DWR Levee Log, 1978. USACE San Joaquin O&M Manual 612.2, 1967, (HLM 2.44)]. FS Date: 6/11/2014

Headwall, flapgate, and grouted spillway on WS slope.

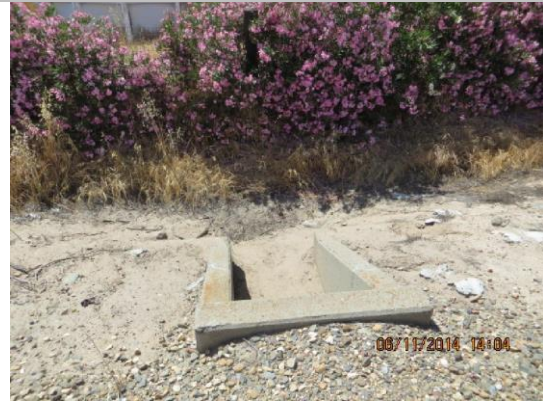
Photo 2 of 3 : UCIP\_FA\_2018\_38546\_70570.jpg

Headwall at LS toe.

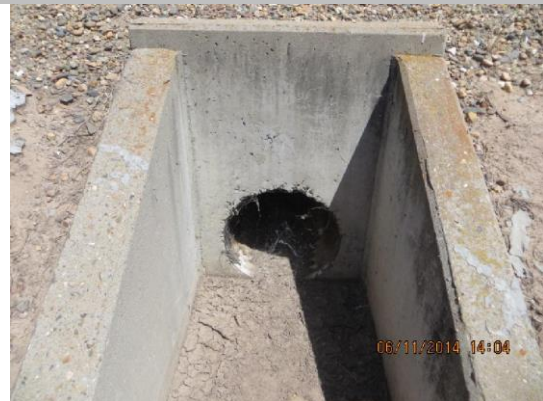
Photo 3 of 3 : UCIP\_FA\_2018\_38546\_70569.jpg

Headwall at LS toe.

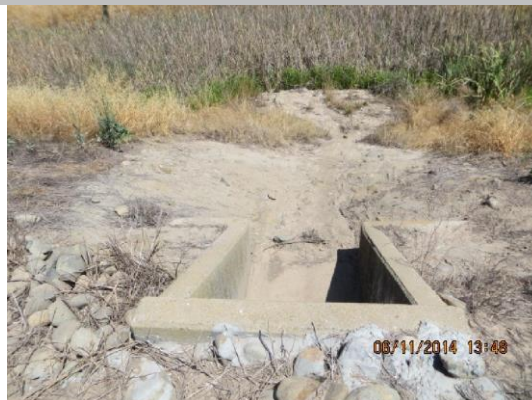
Photo 2 of 3 : UCIP\_FA\_2018\_38542\_70553.jpg

Headwall, flapgate, and grouted spillway on WS slope.

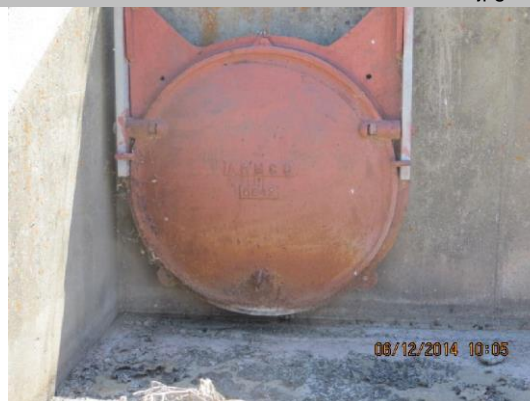
Photo 3 of 3 : UCIP\_FA\_2018\_40788\_70670.jpg

Headwall and flapgate on WS slope.

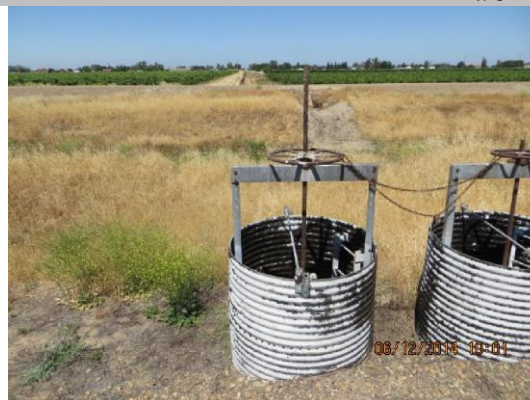
Photo 1 of 3 : UCIP\_FA\_2018\_38569\_70669.jpg

Slide gate in CMP riser on WS slope. No lid on riser and gate rusted in place.

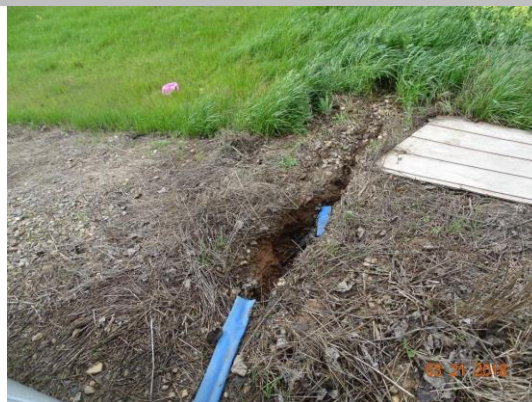
Photo 1 of 1 : FA\_2018\_NA0017\_156\_45\_20180926\_00020.jpg

LM Start	0.43	Rating **	M	Issue No.	45
LM End	0.43	Issue Type +	Ma	Location *	WS
Category	Earthen Levee			GPS Latitude/Longitude	
				Start	End
Item	Erosion / Bank Caving			38.101218 °	38.101218 °
				-121.168226 °	-121.168226 °
DWR ID	DWR_NA0017_12_s_2018_45				
Comment Code					
E2 : Schedule repair of erosion site prior to the next inspection.					
Inspector Comment					
Landowner has a pipe crossing the crown to discharge water from landside. The erosion has been slightly filled in, but is not completely fixed.

Erosion waterside.

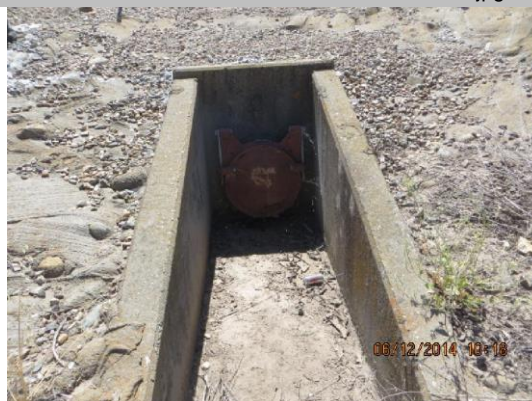
Photo 3 of 3 : UCIP\_FA\_2018\_38574\_70678.jpg

Headwall and flapgate on WS slope.

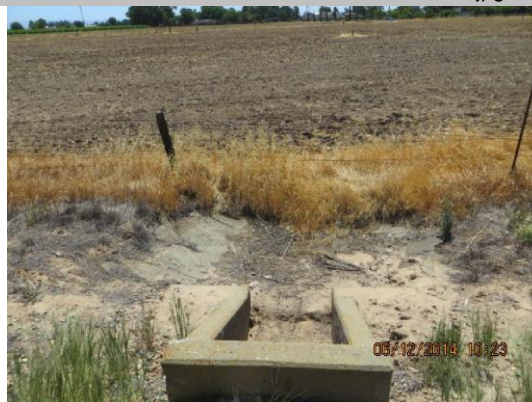
Photo 1 of 3 : UCIP\_FA\_2018\_38576\_70690.jpg

Headwall at LS toe.

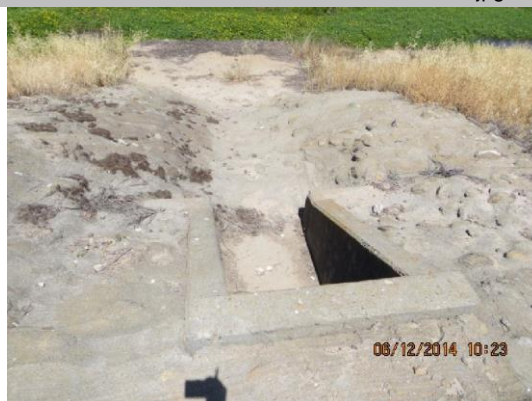
Photo 2 of 3 : UCIP\_FA\_2018\_38576\_70689.jpg

Headwall, flapgate, and grouted spillway on WS slope.

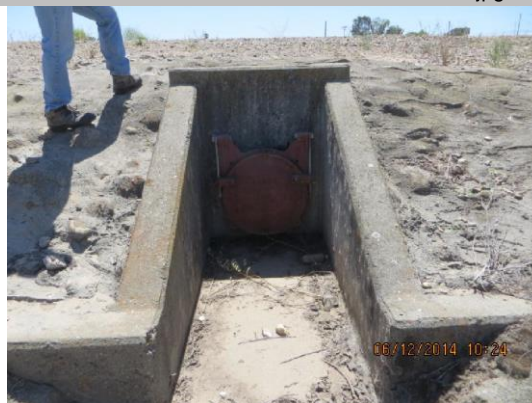
Photo 3 of 3 : UCIP\_FA\_2018\_38576\_70688.jpg

Headwall and flapgate on WS slope.

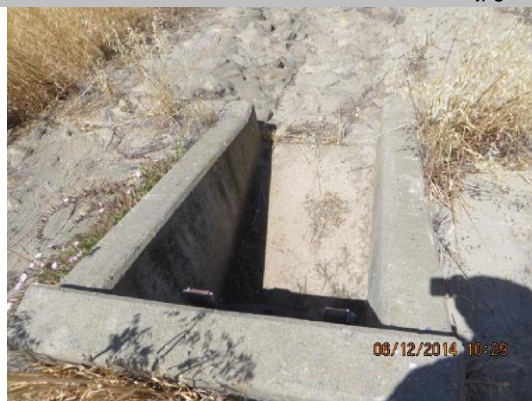
Photo 3 of 3 : UCIP\_FA\_2018\_38577\_70693.jpg

Headwall, flapgate, and grouted spillway on WS slope.

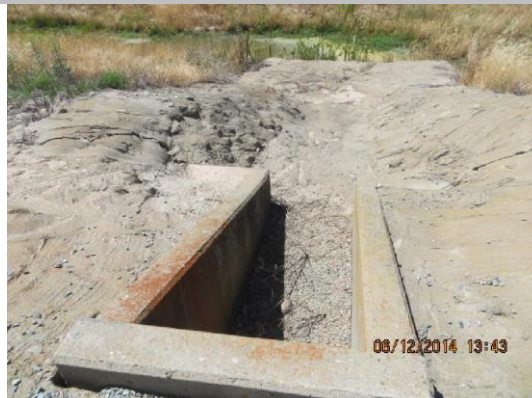
Photo 1 of 3 : UCIP\_FA\_2018\_38624\_70787.jpg

Headwall, flapgate, and grouted spillway on WS slope.

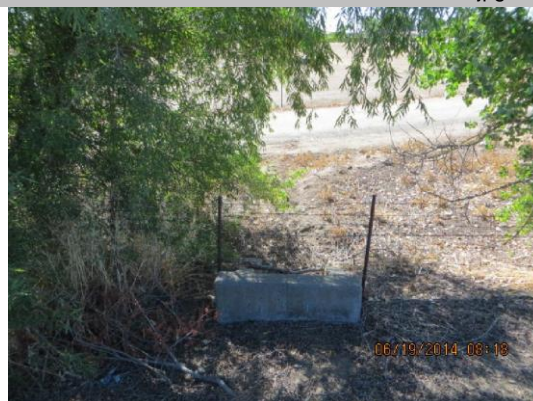
Photo 1 of 3 : UCIP\_FA\_2018\_38632\_70815.jpg

Headwall at LS toe.

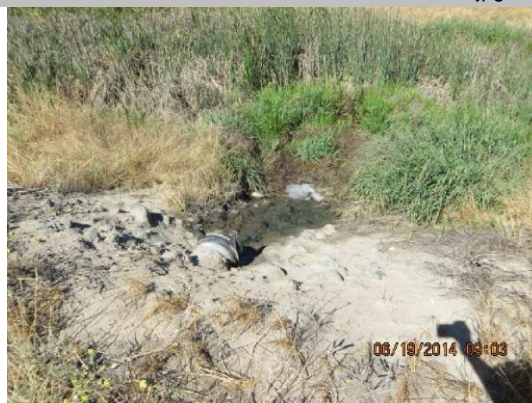
Photo 1 of 3 : UCIP\_FA\_2018\_38638\_70838.jpg

LM Start	2.94	Rating **	A/W	Issue No.	134
LM End	2.94	Issue Type +	Ma	Location *	
Category	Supplemental			GPS Latitude/Longitude	
				Start	End
Item	DWR UCIP LMA Responsibility			38.125894 °	38.125894 °
				-121.143970 °	-121.143970 °
DWR ID	23916				
Comment Code					
Inspector Comment					
FS_ID:38638					
DS_ID:23916					
EP_NO: N/A					
Repair Type: No Action Needed					
Crossing Status: Found					
UCIP Comments:					
FIELD_STRUCT_DESC: 12-inch corrugated metal drainage pipe through the levee, 3 feet below the crown. Flap gate on the waterside (WS) end. Cobble grouted spillway. (Positive closure device installed on intake end under Permit No. 17426, 2003 - Western Dairy Design Associates, Inc.). [Additional Reference(s): DWR Levee Log, 1978. USACE San Joaquin O&M Manual 612.2, 1967, (HLM 2.95)].					
FS Date: 6/19/2014

Flapgate on CMP pipe at WS slope with grouted spillway.

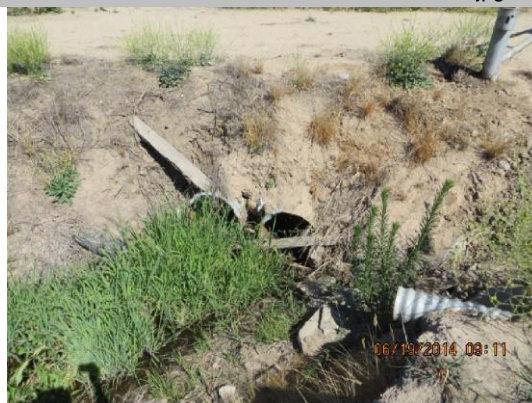
Photo 1 of 3 : UCIP\_FA\_2018\_53519\_70848.jpg

Comment Code					
Inspector Comment					
FS_ID:53519 DS_ID:23928 EP_NO: N/A Repair Type: Urgent Crossing Status: Found UCIP Comments: 11/12/2018 NA0017 found corrosion and holes along the bottom of this CMP drainage culvert. Culvert is also open on both ends. Crossing escalated to "Urgent" due to the extensive corrosion that was found. Internal inspection and/or rehabilitation recommended. (A. McDonald - DWR UCIP)Pipe open on both ends. FIELD_STRUCT_DESC: 1 of 2: 24-inch corrugated metal drainage pipe through the levee, 3 feet below the crown. No closure device or flap gate. [Additional Reference(s): USACE San Joaquin O&M Manual 612.2, 1967, (HLM 3.15)]. FS Date: 11/12/2018

Pipe on LS toe.

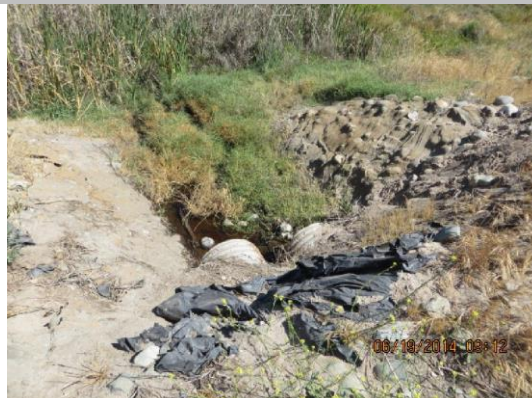
Photo 2 of 3 : UCIP\_FA\_2018\_53519\_70847.jpg

Comment Code						
Inspector Comment						
FS_ID:53519 DS_ID:23928 EP_NO: N/A Repair Type: Urgent Crossing Status: Found UCIP Comments: 11/12/2018 NA0017 found corrosion and holes along the bottom of this CMP drainage culvert. Culvert is also open on both ends. Crossing escalated to "Urgent" due to the extensive corrosion that was found. Internal inspection and/or rehabilitation recommended. (A. McDonald - DWR UCIP)Pipe open on both ends. FIELD_STRUCT_DESC: 1 of 2: 24-inch corrugated metal drainage pipe through the levee, 3 feet below the crown. No closure device or flap gate. [Additional Reference(s): USACE San Joaquin O&M Manual 612.2, 1967, (HLM 3.15)]. FS Date: 11/12/2018

Pipe at grouted spillway on WS slope.

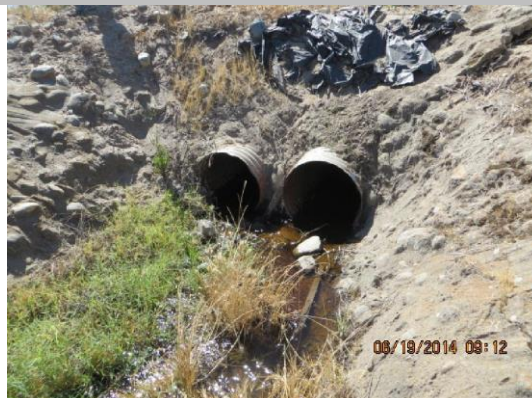
Photo 3 of 3 : UCIP\_FA\_2018\_53519\_70846.jpg

Pipe at grouted spillway on WS slope.

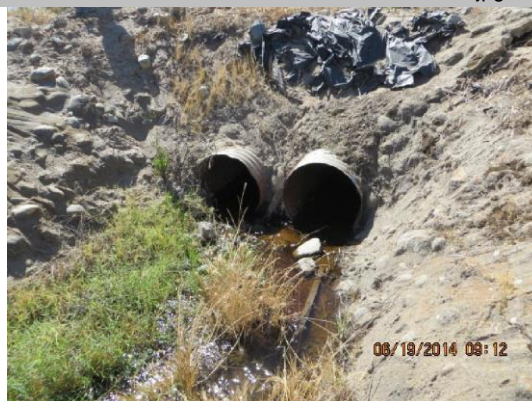
Photo 1 of 3 : UCIP\_FA\_2018\_53520\_70853.jpg

Comment Code						
Inspector Comment						
FS_ID:53520 DS_ID:23926 EP_NO: N/A Repair Type: Urgent Crossing Status: Found UCIP Comments: 11/12/2018 NA0017 found corrosion and holes along the bottom of this CMP drainage culvert. Culvert is also open on both ends. Crossing escalated to "Urgent" due to the extensive corrosion that was found. Internal inspection and/or rehabilitation recommended. (A. McDonald - DWR UCIP)Pipe open with no flapgate. FIELD_STRUCT_DESC: 2 of 2: 24-inch corrugated metal drainage pipe through the levee, 3 feet below the crown. No closure device or flap gate. [Additional Reference(s): USACE San Joaquin O&M Manual 612.2, 1967, (HLM 3.15)]. FS Date: 11/12/2018

Pipe visible on WS slope at grouted spillway.

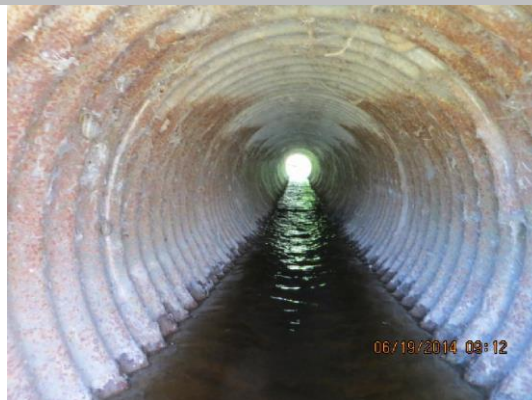
Photo 2 of 3 : UCIP\_FA\_2018\_53520\_70852.jpg

Inside pipe at WS slope.

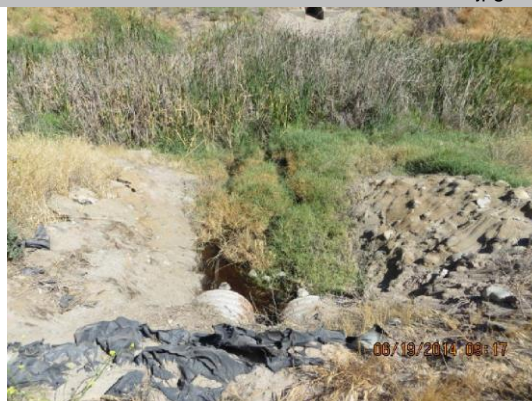
Photo 3 of 3 : UCIP\_FA\_2018\_53520\_70851.jpg

Comment Code						
Inspector Comment						
FS_ID:53520 DS_ID:23926 EP_NO: N/A Repair Type: Urgent Crossing Status: Found UCIP Comments: 11/12/2018 NA0017 found corrosion and holes along the bottom of this CMP drainage culvert. Culvert is also open on both ends. Crossing escalated to "Urgent" due to the extensive corrosion that was found. Internal inspection and/or rehabilitation recommended. (A. McDonald - DWR UCIP)Pipe open with no flapgate. FIELD_STRUCT_DESC: 2 of 2: 24-inch corrugated metal drainage pipe through the levee, 3 feet below the crown. No closure device or flap gate. [Additional Reference(s): USACE San Joaquin O&M Manual 612.2, 1967, (HLM 3.15)]. FS Date: 11/12/2018

Pipe visible on WS slope at grouted spillway.

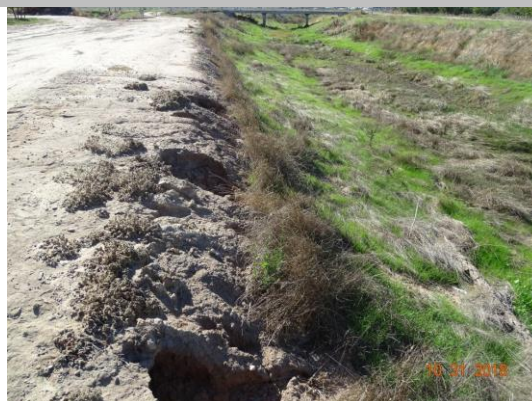
Photo 1 of 1 : FA\_2018\_NA0017\_156\_49\_20181105\_00097.jpg

LM Start	3.13	Rating **	M	Issue No.	49
LM End	3.13	Issue Type +	Ma	Location *	WS
Category	Earthen Levee			GPS Latitude/Longitude	
				Start	End
Item	Erosion / Bank Caving			38.127217 °	38.127217 °
				-121.141445 °	-121.141445 °
DWR ID	DWR_NA0017_12_f_2018_49				
Comment Code					
E2 : Schedule repair of erosion site prior to the next inspection.					
Inspector Comment					
Runoff erosion on the waterside slope.

View of erosion on the waterside slope. Fall 2018.

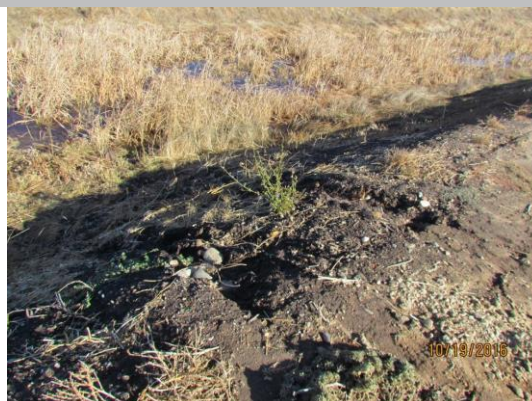
Photo 1 of 2 : FA\_2018\_NA0017\_156\_31\_20180926\_00012.jpg

LM Start	3.14	Rating **	M	Issue No.	31
LM End	3.16	Issue Type +	Ma	Location *	WS
Category	Earthen Levee			GPS Latitude/Longitude	
				Start	End
Item	Erosion / Bank Caving			38.127390°	38.127487°
				-121.141197°	-121.141013°
DWR ID	DWR_NA0017_12_s_2016_31				
Comment Code					
E2 : Schedule repair of erosion site prior to the next inspection.					
Inspector Comment

Updated picture of the erosion on the waterside shoulder of the levee.  
Fall 2016

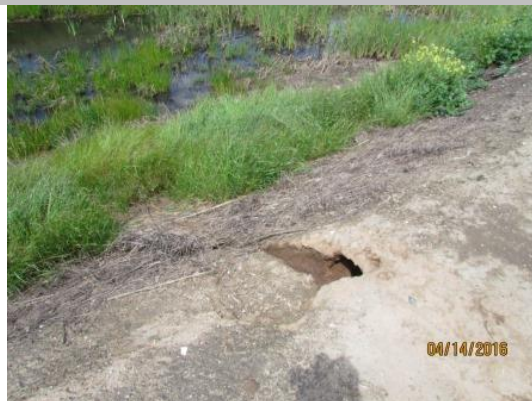
Photo 2 of 2 : FA\_2018\_NA0017\_156\_31\_20180926\_00013.jpg

View of an erosion on the waterside shoulder of the levee.

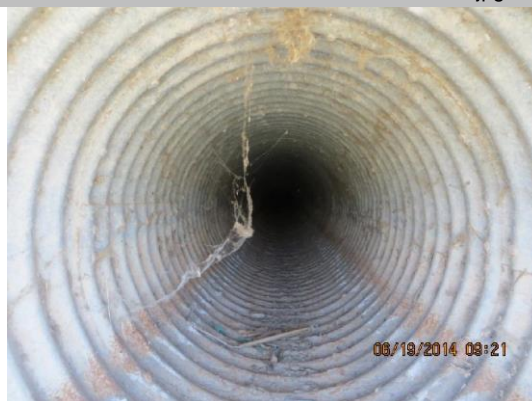
Photo 1 of 3 : UCIP\_FA\_2018\_38643\_70857.jpg

LM Start	3.23	Rating **	A/W	Issue No.	137
LM End	3.23	Issue Type +	Ma	Location *	
Category	Supplemental			GPS Latitude/Longitude	
				Start	End
Item	DWR UCIP LMA Responsibility			38.128162 °	38.128162 °
				-121.139922 °	-121.139922 °
DWR ID	23917				
Comment Code					
Inspector Comment					
FS_ID:38643					
DS_ID:23917					
EP_NO: N/A					
Repair Type: No Action Needed					
Crossing Status: Found					
UCIP Comments: No flapgate					
FIELD_STRUCT_DESC: 24-inch corrugated metal drainage pipe					
through the levee, 4.5 feet below the crown. Cobble grouted spillway.					
Cobble grouted intake on the landside (LS). [Additional Reference(s):					
DWR Levee Log, 1978. USACE San Joaquin O&M Manual 612.2, 1967,					
(HLM 3.25)].					
FS Date: 6/19/2014

Inside pipe at WS slope.

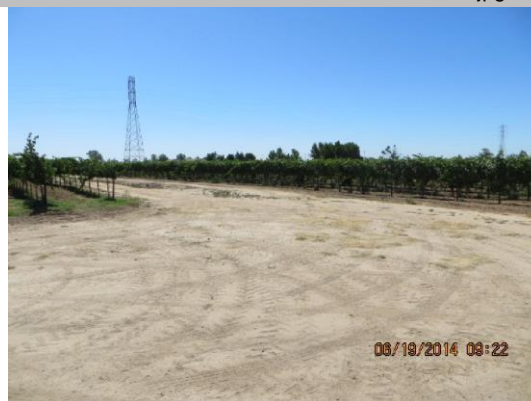
Photo 3 of 3 : UCIP\_FA\_2018\_38643\_70855.jpg

Ditch for inlet well off LS shoulder.
