**Flood Control Project Maintenance  
Levee Inspections**

**Maintenance Issue Types Only, Levee Inspection Report By Mile - Fall 2018**

**San Joaquin County Flood Control and Water Conservation District**

Waterway	Bank	Unit Miles	Inspection Start/End	Inspector
Unit No. 01 Littlejohn Creek	Left	2.59	10/18/2018 10/18/2018	Wade Wylie

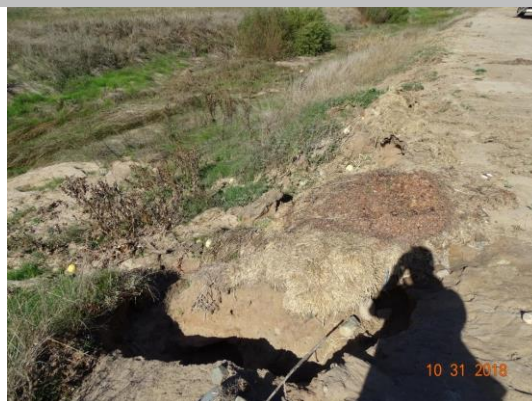
Photo 1 of 1 : FA\_2018\_NA0017\_156\_50\_20181105\_00098.jpg

LM Start	3.37	Rating **	U	Issue No.	50
LM End	3.37	Issue Type +	Ma	Location *	WS
Category	Earthen Levee			GPS Latitude/Longitude	
				Start	End
Item	Erosion / Bank Caving			38.129933 °	38.129933 °
				-121.139209 °	-121.139209 °
DWR ID	DWR_NA0017_12_f_2018_50				
Comment Code					
E2 : Schedule repair of erosion site prior to the next inspection.					
Inspector Comment

View of erosion on the waterside slope. Fall 2018.

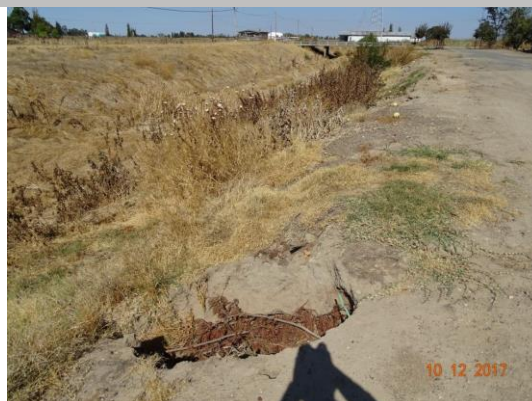
Photo 1 of 1 : FA\_2018\_NA0017\_156\_44\_20180926\_00019.jpg

LM Start	3.45	Rating **	M	Issue No.	44
LM End	3.45	Issue Type +	Ma	Location *	WS
Category	Earthen Levee			GPS Latitude/Longitude	
				Start	End
Item	Erosion / Bank Caving			38.130982 °	38.130982 °
				-121.138597 °	-121.138597 °
DWR ID	DWR_NA0017_12_f_2017_44				
Comment Code					
E2 : Schedule repair of erosion site prior to the next inspection.					
Inspector Comment

View of the erosion on the waterside shoulder of the levee. Fall 2017

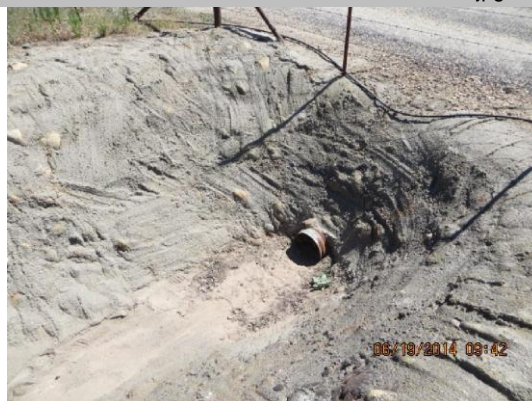
Photo 1 of 3 : UCIP\_FA\_2018\_38646\_70866.jpg

LM Start	3.51	Rating **	A/W	Issue No.	139
LM End	3.51	Issue Type +	Ma	Location *	
Category	Supplemental			GPS Latitude/Longitude	
				Start	End
Item	DWR UCIP LMA Responsibility			38.131725°	38.131725°
				-121.138422°	-121.138422°
DWR ID	23920				
Comment Code					
Inspector Comment					
FS_ID:38646 DS_ID:23920 EP_NO: N/A Repair Type: No Action Needed Crossing Status: Found UCIP Comments: FIELD_STRUCT_DESC: 12-inch corrugated metal drainage pipe through the levee, 4.5 feet below the crown. Cobble grouted spillway. [Additional Reference(s): DWR Levee Log, 1978. USACE San Joaquin O&M Manual 612.2, 1967, (HLM 3.52)]. FS Date: 6/19/2014

Pipe on WS slope.

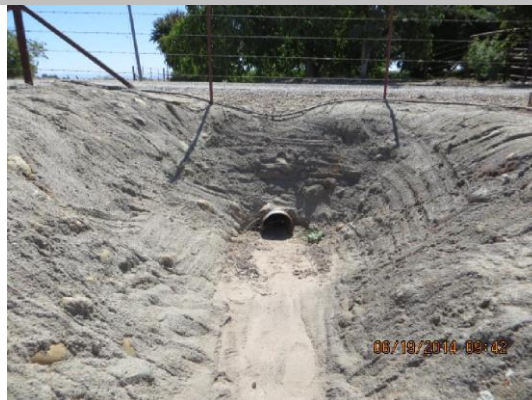
Photo 2 of 3 : UCIP\_FA\_2018\_38646\_70865.jpg

Pipe on WS slope.

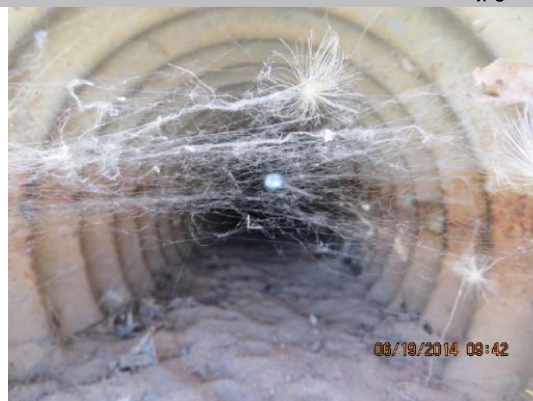
Photo 3 of 3 : UCIP\_FA\_2018\_38646\_70864.jpg

Inside pipe at WS toe.

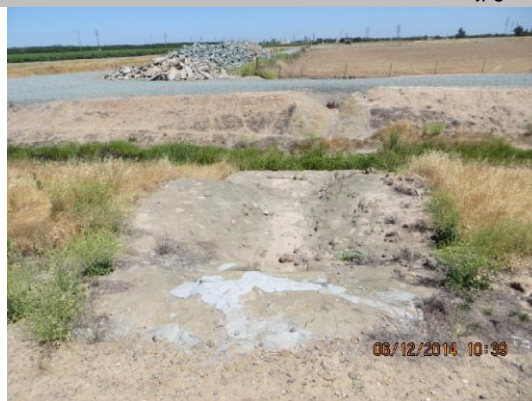
Photo 1 of 3 : UCIP\_FA\_2018\_38578\_70699.jpg

LM Start	0.03	Rating **	A/W	Issue No.	15
LM End	0.03	Issue Type +	Ma	Location *	
Category	Supplemental			GPS Latitude/Longitude	
				Start	End
Item	DWR UCIP LMA Responsibility			38.109370°	38.109370°
				-121.159906°	-121.159906°
DWR ID	23931				
Comment Code					
Inspector Comment					
FS_ID:38578					
DS_ID:23931					
EP_NO: N/A					
Repair Type: No Action Needed					
Crossing Status: Found					
UCIP Comments:					
FIELD_STRUCT_DESC: 24-inch corrugated metal drainage pipe					
through the levee, 5.5 feet below the crown. Concrete U-shaped					
headwall on both ends. Flap gate on the waterside (WS) end.					
[Additional Reference(s): DWR Levee Log, 1978. USACE San Joaquin					
O&M Manual 612.2, 1967, (HLM 0.03)].					
FS Date: 6/12/2014

Headwall, flapgate, and grouted spillway on WS slope.

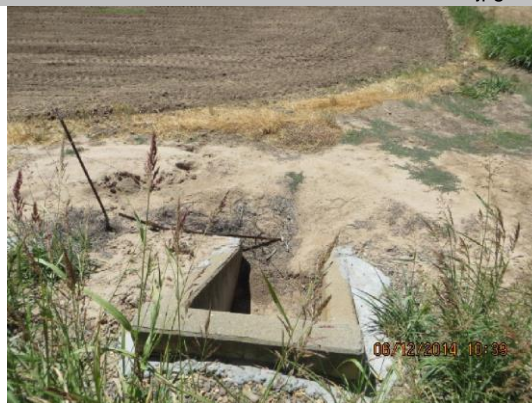
Photo 2 of 3 : UCIP\_FA\_2018\_38578\_70698.jpg

Headwall at LS toe.

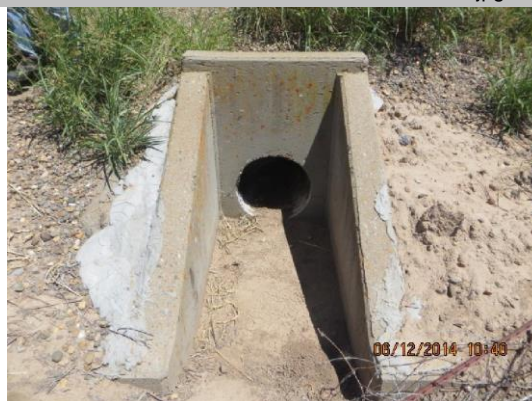
Photo 3 of 3 : UCIP\_FA\_2018\_38578\_70697.jpg

Headwall at LS toe.

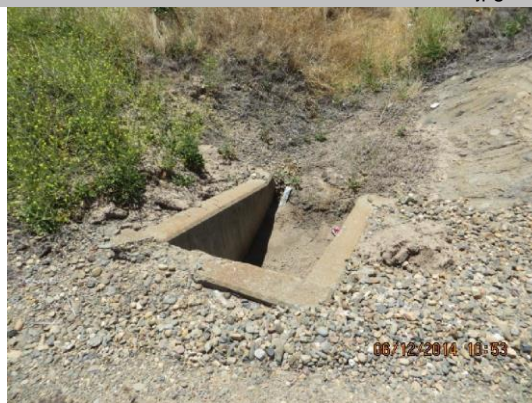
Photo 1 of 3 : UCIP\_FA\_2018\_38581\_70709.jpg

LM Start	0.55	Rating **	A/W	Issue No.	16
LM End	0.55	Issue Type +	Ma	Location *	
Category	Supplemental			GPS Latitude/Longitude	
				Start	End
Item	DWR UCIP LMA Responsibility			38.110925 °	38.110925 °
				-121.150976 °	-121.150976 °
DWR ID	23933				
Comment Code					
Inspector Comment					
FS_ID:38581 DS_ID:23933 EP_NO: N/A Repair Type: No Action Needed Crossing Status: Found UCIP Comments: FIELD_STRUCT_DESC: 24-inch corrugated metal drainage pipe through the levee, 5 feet below the crown. Concrete U-shaped headwall on both ends. Flap gate on the waterside (WS) end. Cobble grouted spillway. Cobble grouted intake on the landside (LS). [Additional Reference(s): DWR Levee Log, 1978. USACE San Joaquin O&M Manual 612.2, 1967, (HLM 0.58)]. FS Date: 6/12/2014

Headwall at LS toe.

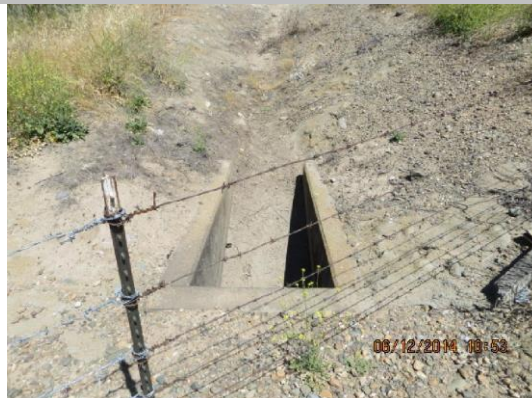
Photo 2 of 3 : UCIP\_FA\_2018\_38581\_70708.jpg

Headwall, flapgate, and grouted spillway on WS slope.

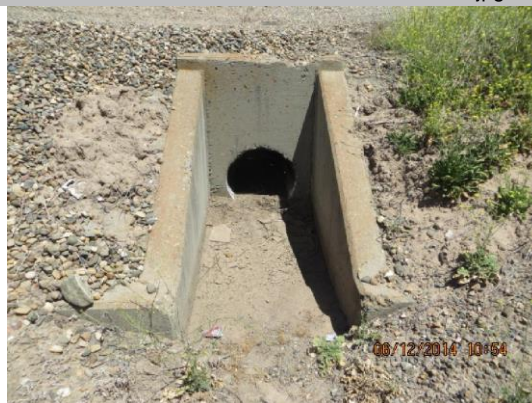
Photo 3 of 3 : UCIP\_FA\_2018\_38581\_70707.jpg

Headwall at LS toe.

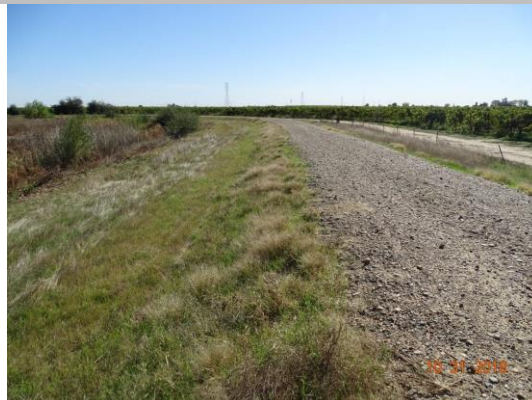
Photo 1 of 1 : FA\_2018\_NA0017\_157\_14\_20181105\_00027.jpg

LM Start	1.22	Rating **	A	Issue No.	14
LM End	1.22	Issue Type +	Ma	Location *	WS
Category	Earthen Levee			GPS Latitude/Longitude	
				Start	End
Item	Vegetation			38.111367°	38.111367°
				-121.141163°	-121.141163°
DWR ID	DWR_NA0017_13_f_2018_14				
Comment Code					
V1 : Control annual grass and weeds on the levee slopes and easements.					
Inspector Comment					
LMA maintains vegetation at a high level.

View of maintained waterside slope. Fall 2018.

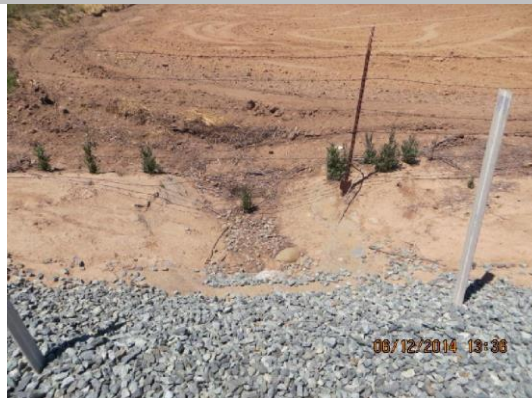
Photo 1 of 3 : UCIP\_FA\_2018\_38623\_70782.jpg

LM Start	0.02	Rating **	A/W	Issue No.	22	
LM End	0.02	Issue Type +	Ma	Location *		
Category	Supplemental			GPS Latitude/Longitude		
				Start	End	
Item	DWR UCIP LMA Responsibility			38.109687 °	38.109687 °	
				-121.159895 °	-121.159895 °	
DWR ID	23939					
Comment Code						
Inspector Comment						
FS_ID:38623						
DS_ID:23939						
EP_NO: N/A						
Repair Type: No Action Needed						
Crossing Status: Found						
UCIP Comments:						
FIELD_STRUCT_DESC: 12-inch corrugated metal drainage pipe through the levee, 3 feet below the crown. Flap gate on the waterside (WS) end. Cobble grouted spillway. Cobble grouted intake on the landside (LS). [Additional Reference(s): DWR Levee Log, 1978. USACE San Joaquin O&M Manual 612.2, 1967, (HLM 0.02)].						
FS Date: 6/12/2014 1:05:17 PM

Pipe at inlet on LS shoulder.

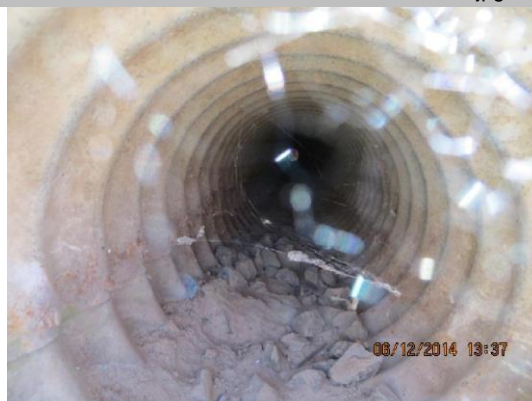
Photo 3 of 3 : UCIP\_FA\_2018\_38623\_70780.jpg

Inside pipe at LS toe.

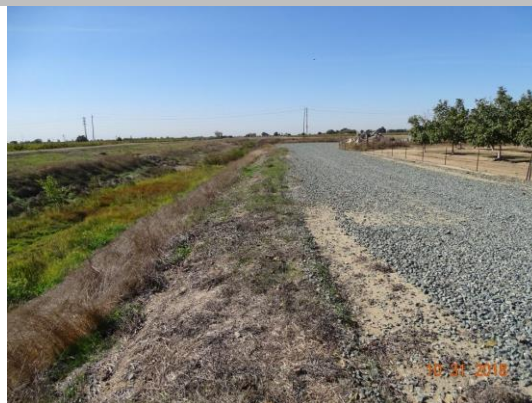
Photo 1 of 1 : FA\_2018\_NA0017\_158\_18\_20181105\_00048.jpg

LM Start	0.05	Rating **	A	Issue No.	18
LM End	0.05	Issue Type +	Ma	Location *	WS
Category	Earthen Levee			GPS Latitude/Longitude	
				Start	End
Item	Vegetation			38.109651 °	38.109651 °
				-121.159315 °	-121.159315 °
DWR ID	DWR_NA0017_14_f_2018_18				
Comment Code					
V1 : Control annual grass and weeds on the levee slopes and easements.					
Inspector Comment					
The LMA maintains the vegetation to a high level.

View of the maintained waterside slope. Fall 2018.

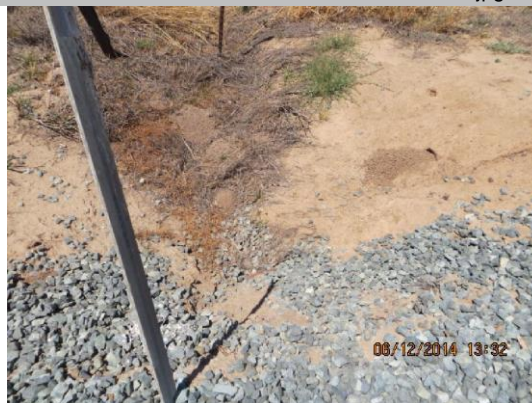
Photo 2 of 3 : UCIP\_FA\_2018\_38615\_70777.jpg

LM Start	0.25	Rating **	M	Issue No.	23	
LM End	0.25	Issue Type +	Ma	Location *		
Category	Supplemental			GPS Latitude/Longitude		
				Start	End	
Item	DWR UCIP LMA Responsibility			38.109799 °	38.109799 °	
				-121.155621 °	-121.155621 °	
DWR ID	23940					
Comment Code						
Inspector Comment						
FS_ID:38615						
DS_ID:23940						
EP_NO: N/A						
Repair Type: Non-Urgent						
Crossing Status: Found						
UCIP Comments: Debris partially blocking closure of flapgate.						
FIELD_STRUCT_DESC: 12-inch corrugated metal drainage pipe						
through the levee, 3 feet below the crown. Flap gate on the waterside						
(WS) end. Cobble grouted spillway. [Additional Reference(s): DWR						
Levee Log, 1978. USACE San Joaquin O&M Manual 612.2, 1967, (HLM						
0.25)].						
FS Date: 6/12/2014

Pipe at inlet on LS shoulder.

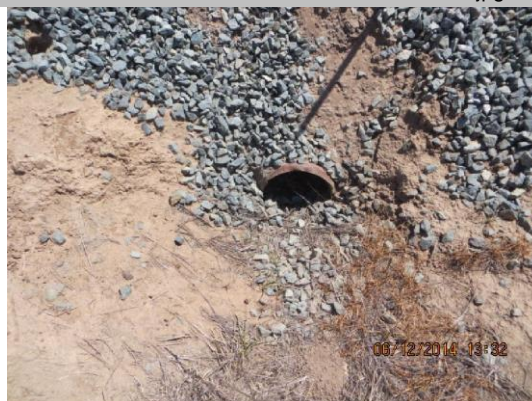
Photo 3 of 3 : UCIP\_FA\_2018\_38615\_70776.jpg

LM Start	0.25	Rating **	M	Issue No.	23 (cont)	
LM End	0.25	Issue Type +	Ma	Location *		
Category	Supplemental			GPS Latitude/Longitude		
				Start	End	
Item	DWR UCIP LMA Responsibility			38.109799 °	38.109799 °	
				-121.155621 °	-121.155621 °	
DWR ID	23940					
Comment Code						
Inspector Comment						
FS_ID:38615						
DS_ID:23940						
EP_NO: N/A						
Repair Type: Non-Urgent						
Crossing Status: Found						
UCIP Comments: Debris partially blocking closure of flapgate.						
FIELD_STRUCT_DESC: 12-inch corrugated metal drainage pipe						
through the levee, 3 feet below the crown. Flap gate on the waterside						
(WS) end. Cobble grouted spillway. [Additional Reference(s): DWR						
Levee Log, 1978. USACE San Joaquin O&M Manual 612.2, 1967, (HLM						
0.25)].						
FS Date: 6/12/2014

Pipe at inlet on LS shoulder.

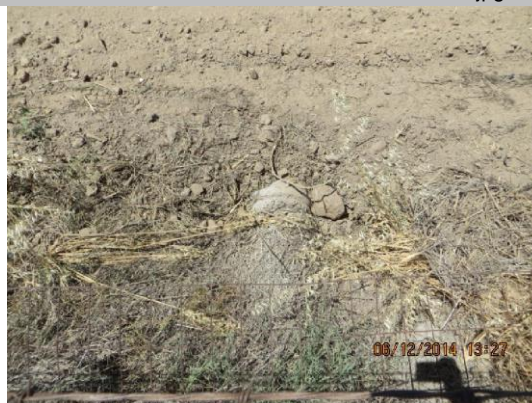
Photo 1 of 3 : UCIP\_FA\_2018\_38614\_70774.jpg

LM Start	0.37	Rating **	M	Issue No.	24
LM End	0.37	Issue Type +	Ma	Location *	
Category	Supplemental			GPS Latitude/Longitude	
				Start	End
Item	DWR UCIP LMA Responsibility			38.109855 °	38.109855 °
				-121.153390 °	-121.153390 °
DWR ID	23941				
Comment Code					
Inspector Comment					
FS_ID:38614					
DS_ID:23941					
EP_NO: N/A					
Repair Type: Non-Urgent					
Crossing Status: Found					
UCIP Comments: Pipe buried on WS slope.					
FIELD_STRUCT_DESC: 12-inch corrugated metal drainage pipe through the levee, 1 foot below the crown. Flap gate on the waterside (WS) end. Cobble grouted spillway. [Additional Reference(s): DWR Levee Log, 1978. USACE San Joaquin O&M Manual 612.2, 1967, (HLM 0.38)].					
FS Date: 6/12/2014

Pipe just visible on LS shoulder.

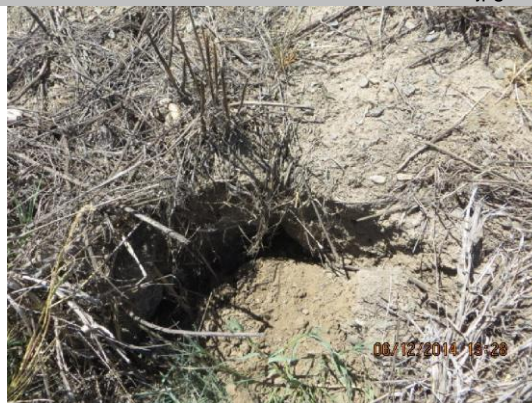
Photo 3 of 3 : UCIP\_FA\_2018\_38614\_70772.jpg

Pipe buried on WS slope.

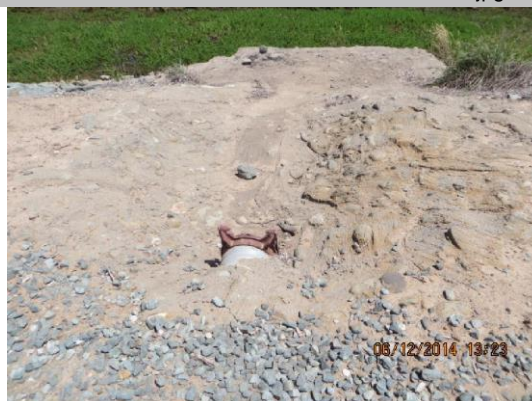
Photo 1 of 3 : UCIP\_FA\_2018\_38613\_70771.jpg

LM Start	0.46	Rating **	A/W	Issue No.	25
LM End	0.46	Issue Type +	Ma	Location *	
Category	Supplemental			GPS Latitude/Longitude	
				Start	End
Item	DWR UCIP LMA Responsibility			38.110456°	38.110456°
				-121.152083°	-121.152083°
DWR ID	23942				
Comment Code					
Inspector Comment					
FS_ID:38613					
DS_ID:23942					
EP_NO: N/A					
Repair Type: No Action Needed					
Crossing Status: Found					
UCIP Comments:					
FIELD_STRUCT_DESC: 12-inch corrugated metal drainage pipe through the levee, 2 feet below the crown. Flap gate on the waterside (WS) end. Cobble grouted spillway. Cobble grouted intake on the landside (LS). [Additional Reference(s): DWR Levee Log, 1978. USACE San Joaquin O&M Manual 612.2, 1967, (HLM 0.46)].					
FS Date: 6/12/2014

Flapgate, pipe, and grouted spillway on WS slope.

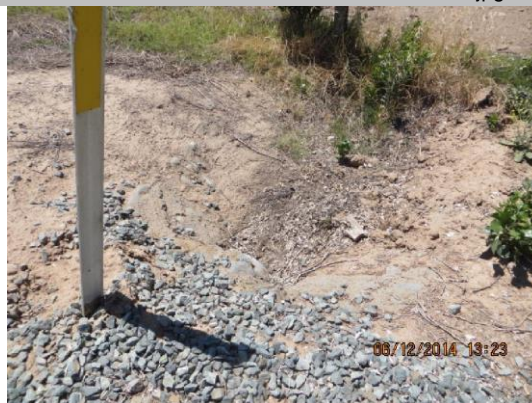
Photo 2 of 3 : UCIP\_FA\_2018\_38613\_70770.jpg

Inlet on LS shoulder.

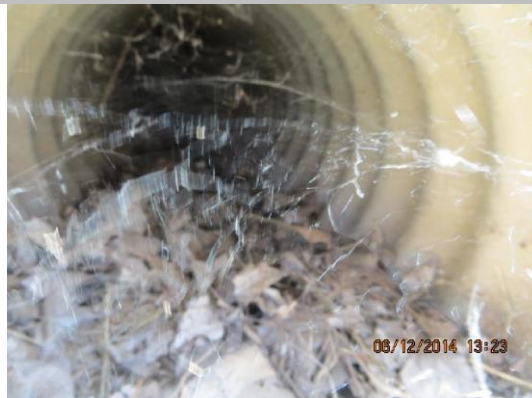
Photo 3 of 3 : UCIP\_FA\_2018\_38613\_70769.jpg

LM Start	0.46	Rating **	A/W	Issue No.	25 (cont)	
LM End	0.46	Issue Type +	Ma	Location *		
Category	Supplemental			GPS Latitude/Longitude		
				Start	End	
Item	DWR UCIP LMA Responsibility			38.110456°	38.110456°	
				-121.152083°	-121.152083°	
DWR ID	23942					
Comment Code						
Inspector Comment						
FS_ID:38613						
DS_ID:23942						
EP_NO: N/A						
Repair Type: No Action Needed						
Crossing Status: Found						
UCIP Comments:						
FIELD_STRUCT_DESC: 12-inch corrugated metal drainage pipe						
through the levee, 2 feet below the crown. Flap gate on the waterside						
(WS) end. Cobble grouted spillway. Cobble grouted intake on the						
landside (LS). [Additional Reference(s): DWR Levee Log, 1978. USACE						
San Joaquin O&M Manual 612.2, 1967, (HLM 0.46)].						
FS Date: 6/12/2014

Inside pipe at LS shoulder.

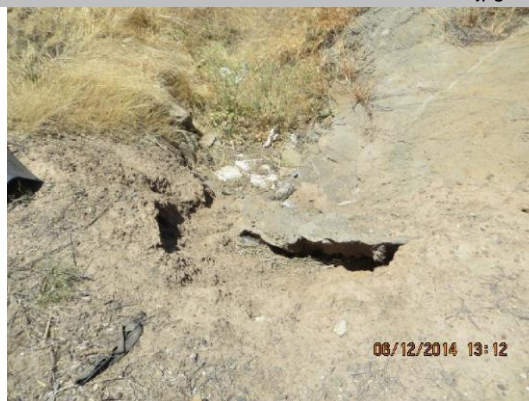
Photo 3 of 3 : UCIP\_FA\_2018\_38610\_70762.jpg

LM Start	0.56	Rating **	A/W	Issue No.	29 (cont)	
LM End	0.56	Issue Type +	Ma	Location *		
Category	Supplemental			GPS Latitude/Longitude		
				Start	End	
Item	DWR UCIP LMA Responsibility			38.111507 °	38.111507 °	
				-121.150745 °	-121.150745 °	
DWR ID	23944					
Comment Code						
Inspector Comment						
FS_ID:38610						
DS_ID:23944						
EP_NO: N/A						
Repair Type: No Action Needed						
Crossing Status: Found						
UCIP Comments:						
FIELD_STRUCT_DESC: 18-inch corrugated metal drainage pipe under the road, 2.5 feet below the crown. Open on both ends. Cobble grouted spillway. Cobble grouted intake on the landside (LS). [Additional Reference(s): DWR Levee Log, 1978. USACE San Joaquin O&M Manual 612.2, 1967, (HLM 0.57)].						
FS Date: 6/12/2014

Pipe at LS toe.

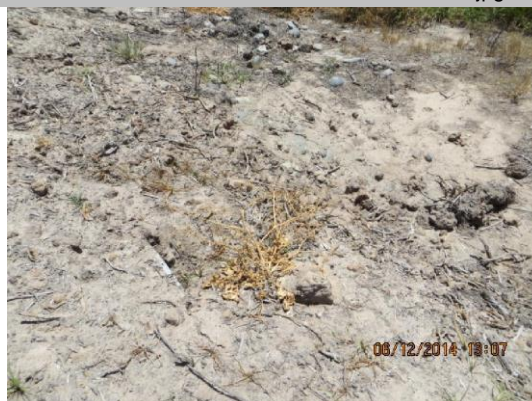
Photo 1 of 3 : UCIP\_FA\_2018\_41365\_70758.jpg

LM Start	0.75	Rating **	M	Issue No.	30	
LM End	0.75	Issue Type +	Ma	Location *		
Category	Supplemental			GPS Latitude/Longitude		
				Start	End	
Item	DWR UCIP LMA Responsibility			38.111475 °	38.111475 °	
				-121.148081 °	-121.148081 °	
DWR ID	23945					
Comment Code						
Inspector Comment						
FS_ID:41365						
DS_ID:23945						
EP_NO: N/A						
Repair Type: Non-Urgent						
Crossing Status: Found						
UCIP Comments: Pipe open on both ends. Levee appears abandoned.						
FIELD_STRUCT_DESC: 24-inch corrugated metal drainage pipe						
through the levee, 1 foot below the crown. Cobble grouted spillway.						
Cobble grouted intake on the landside (LS). Open on both ends.						
[Additional Reference(s): DWR Levee Log, 1978. USACE San Joaquin						
O&M Manual 612.2, 1967, (HLM 0.76)].						
FS Date: 6/12/2014

Pipe on WS slope.

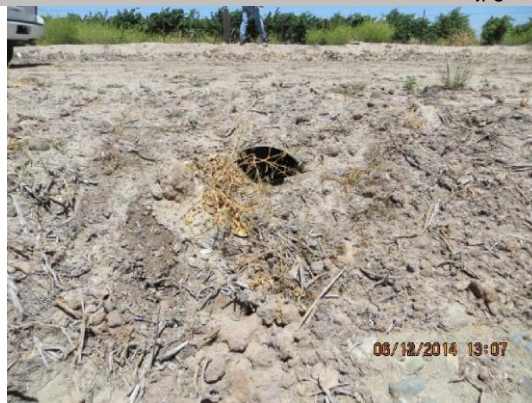
Photo 2 of 3 : UCIP\_FA\_2018\_41365\_70757.jpg

Pipe on WS slope.

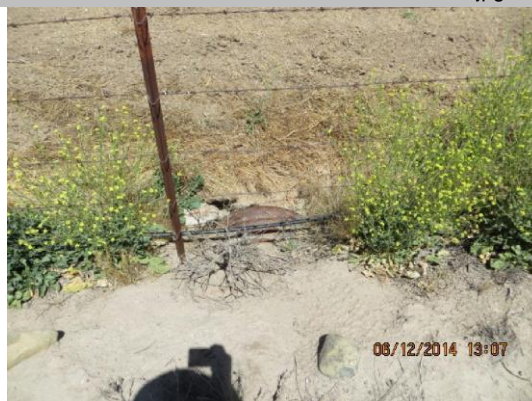
Photo 3 of 3 : UCIP\_FA\_2018\_41365\_70756.jpg

LM Start	0.75	Rating **	M	Issue No.	30 (cont)	
LM End	0.75	Issue Type +	Ma	Location *		
Category	Supplemental			GPS Latitude/Longitude		
				Start	End	
Item	DWR UCIP LMA Responsibility			38.111475 °	38.111475 °	
				-121.148081 °	-121.148081 °	
DWR ID	23945					
Comment Code						
Inspector Comment						
FS_ID:41365						
DS_ID:23945						
EP_NO: N/A						
Repair Type: Non-Urgent						
Crossing Status: Found						
UCIP Comments: Pipe open on both ends. Levee appears abandoned.						
FIELD_STRUCT_DESC: 24-inch corrugated metal drainage pipe						
through the levee, 1 foot below the crown. Cobble grouted spillway.						
Cobble grouted intake on the landside (LS). Open on both ends.						
[Additional Reference(s): DWR Levee Log, 1978. USACE San Joaquin						
O&M Manual 612.2, 1967, (HLM 0.76)].						
FS Date: 6/12/2014

Pipe on LS shoulder.

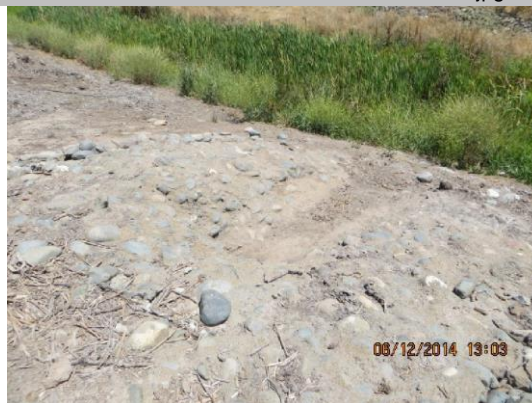
Photo 1 of 3 : UCIP\_FA\_2018\_41791\_70755.jpg

LM Start	0.94	Rating **	M	Issue No.	31
LM End	0.94	Issue Type +	Ma	Location *	
Category	Supplemental			GPS Latitude/Longitude	
				Start	End
Item	DWR UCIP LMA Responsibility			38.110801°	38.110801°
				-121.145174°	-121.145174°
DWR ID	23946				
Comment Code					
Inspector Comment					
FS_ID:41791					
DS_ID:23946					
EP_NO: N/A					
Repair Type: Non-Urgent					
Crossing Status: Found					
UCIP Comments: Pipe buried on LS. Levee appears abandoned.					
FIELD_STRUCT_DESC: *ABANDONED* 12-inch corrugated metal drainage pipe through the levee, 2 feet below the crown. Open on both ends. Cobble grouted spillway. [Additional Reference(s): DWR Levee Log, 1978. USACE San Joaquin O&M Manual 612.2, 1967, (HLM 0.95)].					
FS Date: 6/12/2014

Pipe and grouted spillway on WS slope.

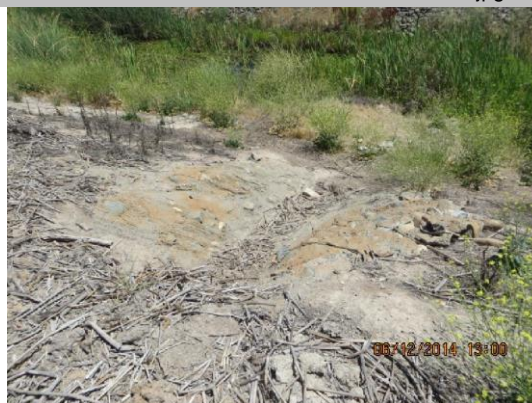
Photo 1 of 2 : UCIP\_FA\_2018\_41792\_70752.jpg

LM Start	0.96	Rating **	M	Issue No.	32
LM End	0.96	Issue Type +	Ma	Location *	
Category	Supplemental			GPS Latitude/Longitude	
				Start	End
Item	DWR UCIP LMA Responsibility			38.110926 °	38.110926 °
				-121.144799 °	-121.144799 °
DWR ID	23947				
Comment Code					
Inspector Comment					
FS_ID:41792					
DS_ID:23947					
EP_NO: N/A					
Repair Type: Non-Urgent					
Crossing Status: Found					
UCIP Comments: Pipe burried on LS shoulder and open on WS.					
Levee appears abandoned.					
FIELD_STRUCT_DESC: *ABANDONED* 18-inch corrugated metal drainage pipe through the levee, 3 feet below the crown. Open on both ends. Cobble grouted spillway. Cobble grouted intake on the landside (LS). [Additional Reference(s): DWR Levee Log, 1978. USACE San Joaquin O&M Manual 612.2, 1967, (HLM 0.97)].					
FS Date: 6/12/2014

Pipe and grouted spillway on WS slope.

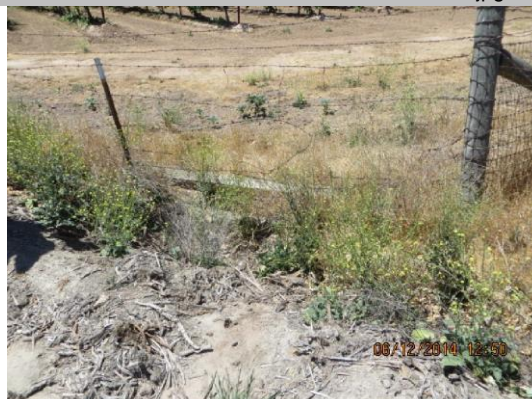
Photo 1 of 3 : UCIP\_FA\_2018\_41793\_70746.jpg

LM Start	1.11	Rating **	M	Issue No.	34	
LM End	1.11	Issue Type +	Ma	Location *		
Category	Supplemental			GPS Latitude/Longitude		
				Start		End
Item	DWR UCIP LMA Responsibility			38.112125 °		38.112125 °
				-121.142568 °		-121.142568 °
DWR ID	23949					
Comment Code						
Inspector Comment						
FS_ID:41793 DS_ID:23949 EP_NO: N/A Repair Type: Non-Urgent Crossing Status: Found UCIP Comments: Pipe appears abandoned. Levee appears Abandoned. FIELD_STRUCT_DESC: *ABANDONED* 12-inch corrugated metal drainage pipe through the levee, 2.5 feet below the crown. Flap gate on the waterside (WS) end. Cobble grouted spillway. Cobble grouted intake on the landside (LS). [Additional Reference(s): DWR Levee Log, 1978. USACE San Joaquin O&M Manual 612.2, 1967, (HLM 1.12)]. FS Date: 6/12/2014

LS of levee at pipe. Pipe largely filled in with soil.

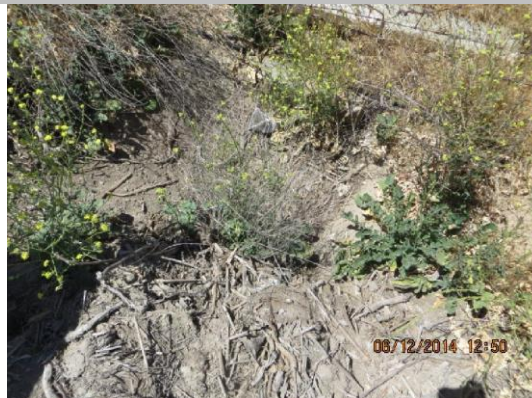
Photo 2 of 3 : UCIP\_FA\_2018\_41793\_70745.jpg

LS of levee at pipe. Pipe largely filled in with soil.

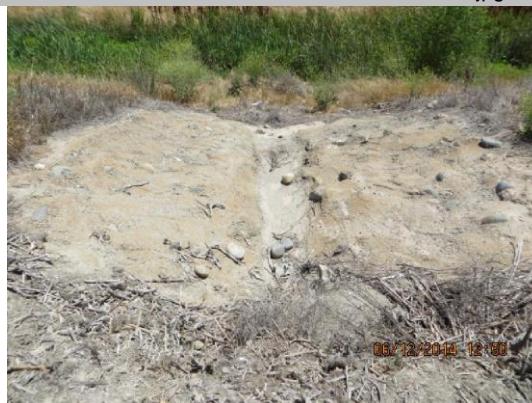
Photo 3 of 3 : UCIP\_FA\_2018\_41793\_70744.jpg

Pipe, flapgate, and grouted spillway on WS slope.

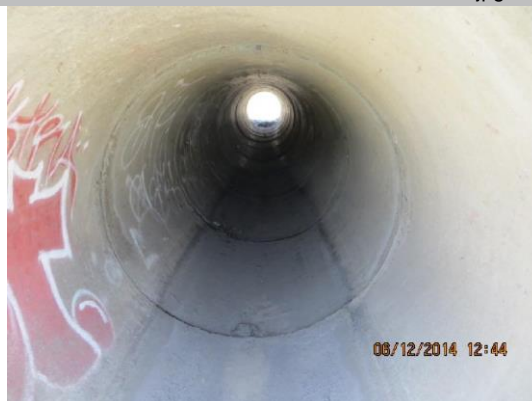
Photo 2 of 3 : UCIP\_FA\_2018\_41794\_70741.jpg

Inside pipe.

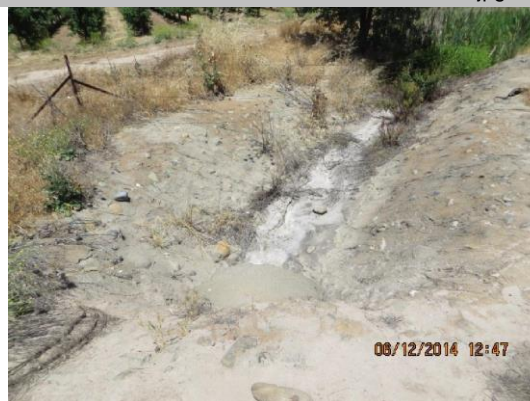
Photo 3 of 3 : UCIP\_FA\_2018\_41794\_70740.jpg

Pipe at LS intake.

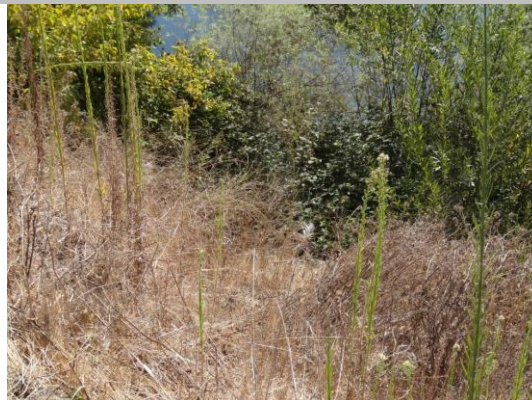
Photo 1 of 4 : FA\_2018\_NA0017\_159\_7\_20181001\_00014.jpg

Comment Code					
Inspector Comment					
08/30/2017: No significant change observed.					
08/16/2016: No significant change observed.					
08/12/2015: No significant change observed.					
08/20/2014: No significant change has been observed.					
09/12/2013: No significant change observed.					
08/22/2012: Site has been revisited. No significant change observed.					
09/02/2011: No significant change observed on site.					
11/02/2010: No significant change observed. The mile-long erosion continues to degrade the bank. There are a few trees along the mile-long stretch on the lower bank slope that are affected by the scarp. WS Levee Slope was changed to 2:1. As a result, normalized score increased from 62 to 65.					
08/05/2010: Recommended for waterside repair, per CLRO; "water velocity is a major factor for accelerating bank slope erosion."					
8/12/2009: Near-vertical bank erosion; degrading channel is incising the banks; recommend annual assessment and monitoring of critical erosion site, per CLRO CES Evaluation 2008 Report; district is monitoring site for change in condition; site was previously rated "U".

Looking at the site from the levee top.

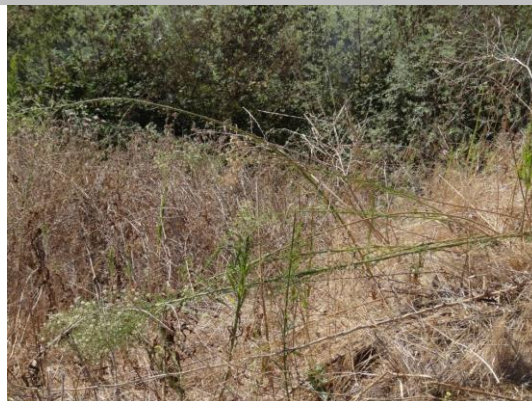
Photo 2 of 4 : FA\_2018\_NA0017\_159\_7\_20181001\_00015.jpg

Close view of the erosion. Note dense vegetation and trees on site.

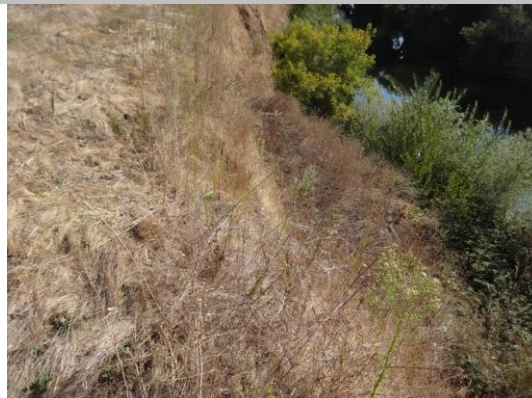
Photo 3 of 4 : FA\_2018\_NA0017\_159\_7\_20181001\_00016.jpg

Item	DWR Erosion Survey			38.045658 °	38.045658 °	
				-121.023741 °	-121.023741 °	
DWR ID	NA0017U15RM22.91					
Comment Code						
Inspector Comment						
08/30/2017: No significant change observed.						
08/16/2016: No significant change observed.						
08/12/2015: No significant change observed.						
08/20/2014: No significant change has been observed.						
09/12/2013: No significant change observed.						
08/22/2012: Site has been revisited. No significant change observed.						
09/02/2011: No significant change observed on site.						
11/02/2010: No significant change observed. The mile-long erosion continues to degrade the bank. There are a few trees along the mile-long stretch on the lower bank slope that are affected by the scarp. WS Levee Slope was changed to 2:1. As a result, normalized score increased from 62 to 65.						
08/05/2010: Recommended for waterside repair, per CLRO; "water velocity is a major factor for accelerating bank slope erosion."

8/12/2009: Near-vertical bank erosion; degrading channel is incising the banks; recommend annual assessment and monitoring of critical erosion site, per CLRO CES Evaluation 2008 Report; district is monitoring site for change in condition; site was previously rated "U".						
2007: Visited site 02/06/2007; possible critical site. [2017 Site ID:NA0017U15RM22.91]

Close view of the erosion.

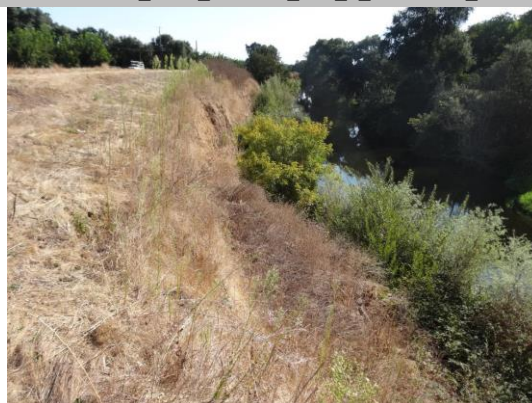
Photo 4 of 4 : FA\_2018\_NA0017\_159\_7\_20181001\_00017.jpg

Looking upstream at the site.

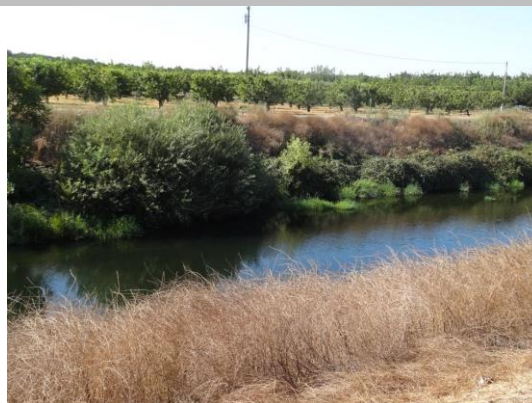
Photo 1 of 4 : FA\_2018\_NA0017\_159\_6\_20181001\_00010.jpg

LM Start	1.78	Rating **	U	Issue No.	6
LM End	1.79	Issue Type +	Ma	Location *	WS
Category	Supplemental			GPS Latitude/Longitude	
				Start	End
Item	DWR Erosion Survey			38.039110 °	38.039110 °
				-121.037840 °	-121.037840 °
DWR ID	NA0017U15RM22.01				
Comment Code					
Inspector Comment					
08/30/2017: No significant change observed.					
08/16/2016: No significant change observed.					
08/12/2015: No significant change observed.					
08/20/2014: No significant change observed.					
09/12/2013: No significant change observed.					
08/22/2012: Site is covered with dense vegetation. A scarp erosion is adjacent to a pocket erosion at the downstream. There is no levee structure on site. The levee crest width and levee height were not measured or estimated in the field. [2017 Site ID:NA0017U15RM22.01]

Front view of the erosion site from the left river bank.

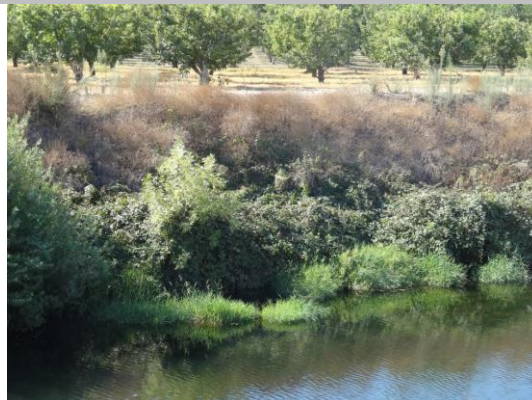
Photo 2 of 4 : FA\_2018\_NA0017\_159\_6\_20181001\_00011.jpg

Front view of the pocket erosion covered by dense vegetation.

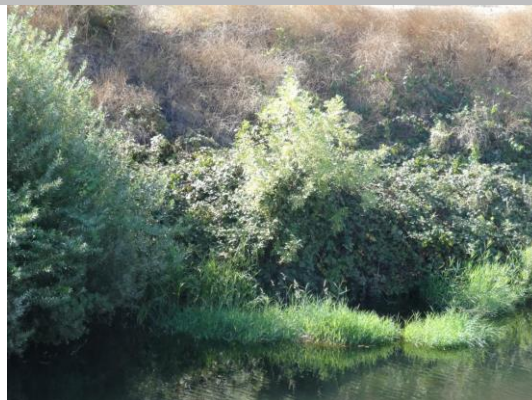
Photo 3 of 4 : FA\_2018\_NA0017\_159\_6\_20181001\_00012.jpg

Close view of the pocket erosion.

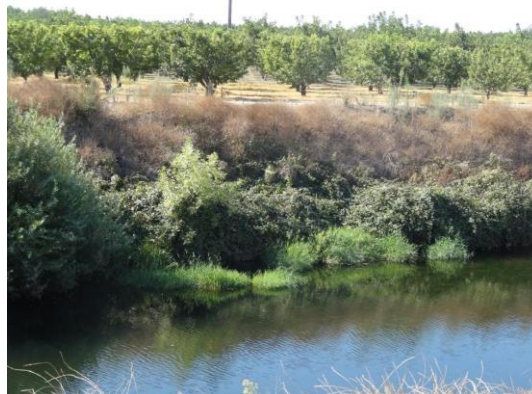
Photo 4 of 4 : FA\_2018\_NA0017\_159\_6\_20181001\_00013.jpg

Close view of the erosion.

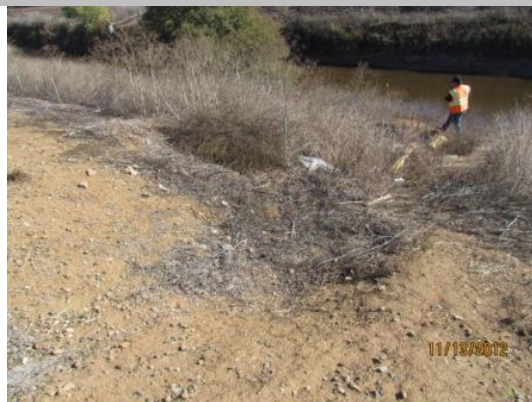
Photo 1 of 2 : FA\_2018\_NA0017\_159\_18\_20181001\_00022.jpg

LM Start	2.05	Rating **	M	Issue No.	18
LM End	2.05	Issue Type +	Ma	Location *	WS
Category	Earthen Levee			GPS Latitude/Longitude	
				Start	End
Item	Slope Stability			38.036294°	38.036294°
				-121.041089°	-121.041089°
DWR ID	DWR_NA0017_15_s_2012_18				
Comment Code					
S1 : Repair slope instability.					
Inspector Comment

Updated picture of the slope instability at the waterside slope of the levee looking upstream.

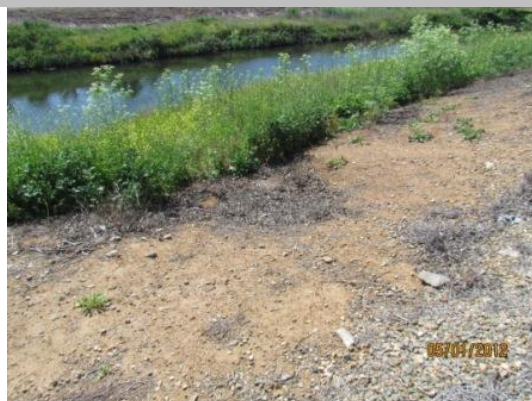
Photo 2 of 2 : FA\_2018\_NA0017\_159\_18\_20181001\_00023.jpg

Slope instability was found on the waterside toe of the levee looking downstream.

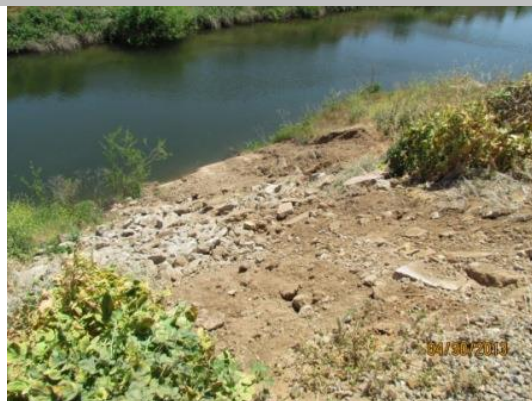
Photo 1 of 2 : FA\_2018\_NA0017\_159\_43\_20181001\_00035.jpg

LM Start	3.78	Rating **	M	Issue No.	43
LM End	3.78	Issue Type +	Ma	Location *	WS
Category	Earthen Levee			GPS Latitude/Longitude	
				Start	End
Item	Slope Stability			38.019119°	38.019119°
				-121.064034°	-121.064034°
DWR ID	DWR_NA0017_15_f_2012_43				
Comment Code					
S1 : Repair slope instability.					
Inspector Comment

Updated picture of the slope instability on the waterside slope of the levee looking downstream.

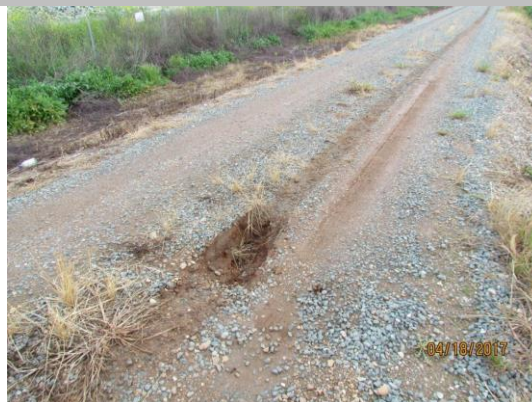
Photo 1 of 1 : FA\_2018\_NA0017\_159\_179\_20181001\_00109.jpg

LM Start	3.79	Rating **	M	Issue No.	179
LM End	3.79	Issue Type +	Ma	Location *	CR
Category	Earthen Levee			GPS Latitude/Longitude	
				Start	End
Item	Crown Surface / Depressions / Rutting			38.019002°	38.019002°
				-121.064182°	-121.064182°
DWR ID	DWR_NA0017_15_s_2017_179				
Comment Code					
C2 : Repair depressions or ruts in the crown or slope.					
Inspector Comment

View of a crown depression on the levee.

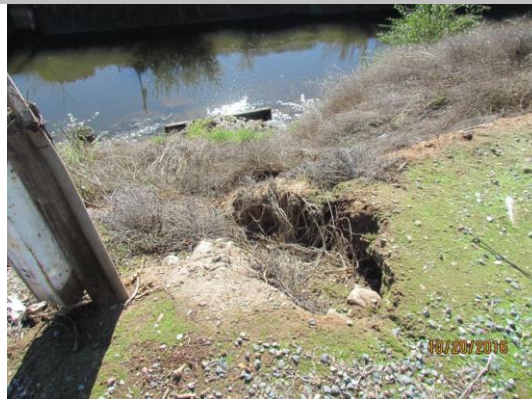
Photo 1 of 2 : FA\_2018\_NA0017\_159\_44\_20181001\_00037.jpg

LM Start	3.90	Rating **	M	Issue No.	44
LM End	3.90	Issue Type +	Ma	Location *	WS
Category	Earthen Levee			GPS Latitude/Longitude	
				Start	End
Item	Slope Stability			38.017871°	38.017871°
				-121.065357°	-121.065357°
DWR ID	DWR_NA0017_15_f_2012_44				
Comment Code					
S1 : Repair slope instability.					
Inspector Comment

Updated picture of the slope instability on the waterside shoulder of the levee. Fall 2016

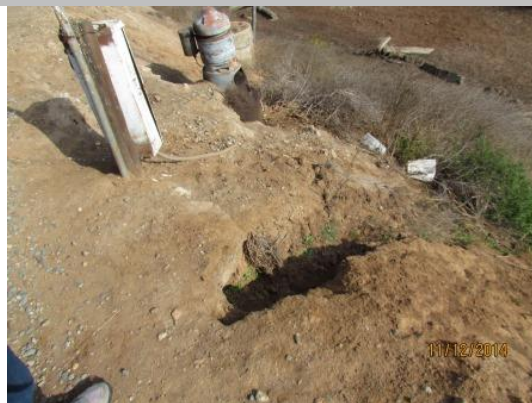
Photo 2 of 2 : FA\_2018\_NA0017\_159\_44\_20181001\_00038.jpg

LM Start	<b>3.90</b>	Rating **	M	Issue No.	<b>44 (cont)</b>
LM End	<b>3.90</b>	Issue Type +	Ma	Location *	WS

Updated picture of the slope instability on the waterside slope of the levee looking upstream. This picture was taken during fall 2014 inspection.

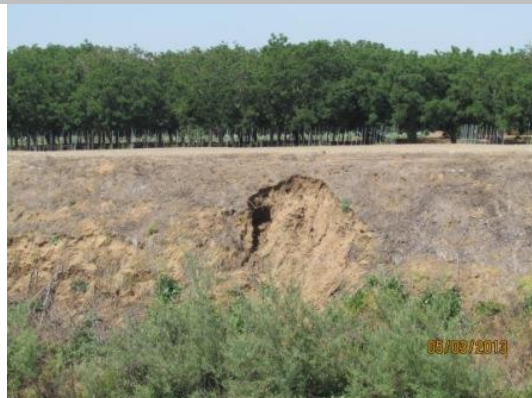
Photo 1 of 1 : FA\_2018\_NA0017\_159\_124\_20181001\_00073.jpg

LM Start	4.28	Rating **	U	Issue No.	124
LM End	4.28	Issue Type +	Ma	Location *	WS
Category	Earthen Levee			GPS Latitude/Longitude	
				Start	End
Item	Animal Control			38.013122°	38.013122°
				-121.068467°	-121.068467°
DWR ID	DWR_NA0017_15_s_2013_124				
Comment Code					
A3 : No rodents visible, but rodent burrows visible; need to backfill and compact or grout burrows.					
Inspector Comment					
Picture was taken from the other side of the levee.

An animal hole was found on the waterside slope of the levee. The picture was taken from the opposite side of the levee.

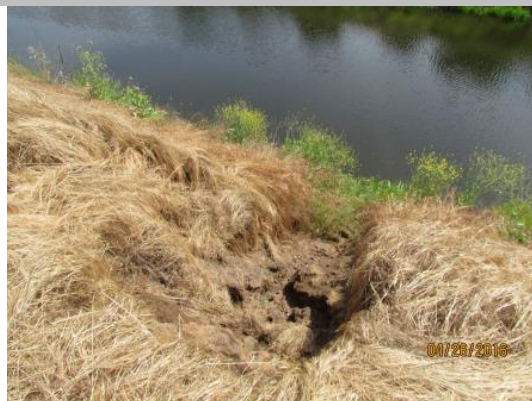
Photo 1 of 2 : FA\_2018\_NA0017\_159\_133\_20181001\_00075.jpg

LM Start	4.51	Rating **	M	Issue No.	133
LM End	4.51	Issue Type +	Ma	Location *	WS
Category	Earthen Levee			GPS Latitude/Longitude	
				Start	End
Item	Erosion / Bank Caving			38.009753 °	38.009753 °
				-121.069559 °	-121.069559 °
DWR ID	DWR_NA0017_15_f_2015_133				
Comment Code					
E2 : Schedule repair of erosion site prior to the next inspection.					
Inspector Comment

Updated view of the erosion on the waterside shoulder during spring 2016 inspection.

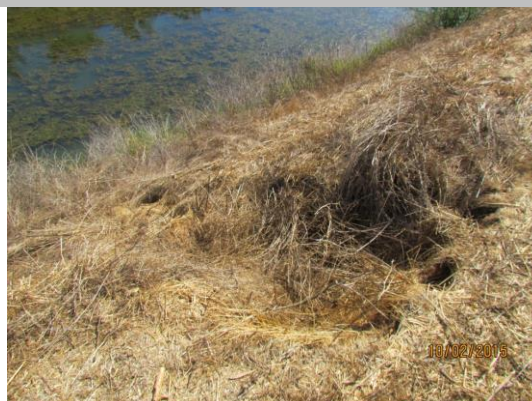
Photo 2 of 2 : FA\_2018\_NA0017\_159\_133\_20181001\_00076.jpg

LM Start	<b>4.51</b>	Rating **	M	Issue No.	<b>133 (cont)</b>
LM End	<b>4.51</b>	Issue Type +	Ma	Location *	WS

Erosion was found on the waterside shoulder of the levee looking downstream.

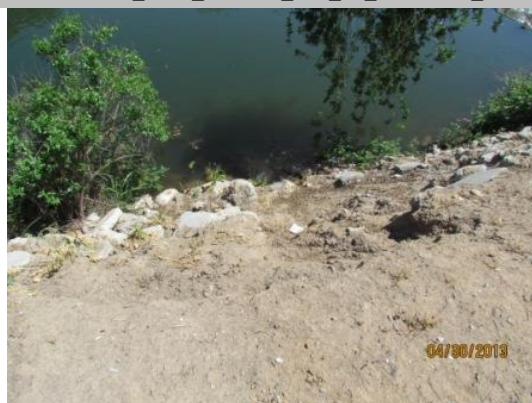
Photo 1 of 3 : FA\_2018\_NA0017\_159\_96\_20181001\_00063.jpg

LM Start	4.63	Rating **	A/W	Issue No.	96
LM End	4.63	Issue Type +	Ma	Location *	WS
Category	Earthen Levee			GPS Latitude/Longitude	
				Start	End
Item	Erosion / Bank Caving			38.008053 °	38.008053 °
				-121.070141 °	-121.070141 °
DWR ID	DWR_NA0017_15_s_2012_96				
Comment Code					
E1 : Note and monitor erosion site.					
Inspector Comment					
LMA has fixed the issue but the riprap has rebar which can be dangerous during a flood fighting effort.

Updated picture of the slope instability on the waterside slope of the levee looking downstream during spring 2013 inspection.

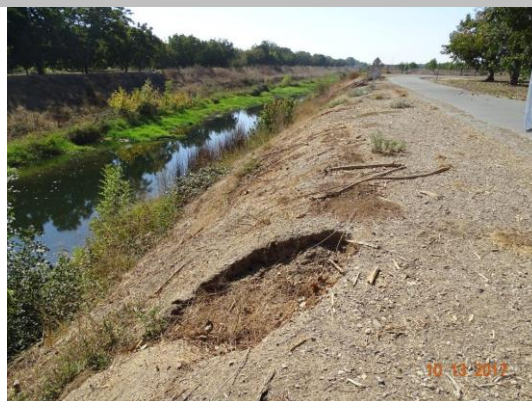
Photo 1 of 1 : FA\_2018\_NA0017\_159\_161\_20181001\_00098.jpg

LM Start	5.43	Rating **	A/W	Issue No.	161
LM End	5.43	Issue Type +	Ma	Location *	WS
Category	Earthen Levee			GPS Latitude/Longitude	
				Start	End
Item	Erosion / Bank Caving			37.998297°	37.998297°
				-121.077821°	-121.077821°
DWR ID	DWR_NA0017_15_f_2017_161				
Comment Code					
E1 : Note and monitor erosion site.					
Inspector Comment					
This portion of the levee is non-project. Therefore, the rating was given A/W.

View of erosion on the waterside slope of the levee. Fall 2017

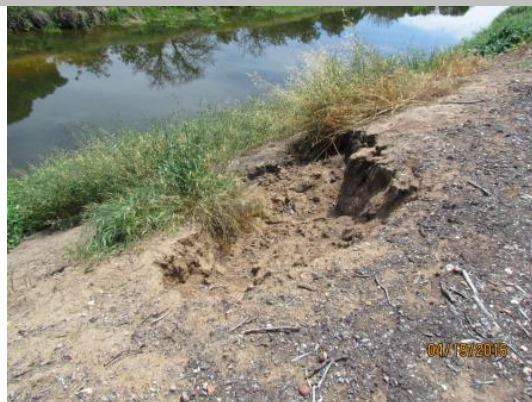
Photo 1 of 1 : FA\_2018\_NA0017\_159\_202\_20181001\_00123.jpg

LM Start	5.52	Rating **	A/W	Issue No.	202
LM End	5.52	Issue Type +	Ma	Location *	WS
Category	Earthen Levee			GPS Latitude/Longitude	
				Start	End
Item	Erosion / Bank Caving			37.997257 °	37.997257 °
				-121.078775 °	-121.078775 °
DWR ID	DWR_NA0017_15_s_2016_202				
Comment Code					
E2 : Schedule repair of erosion site prior to the next inspection.					
Inspector Comment					
This portion of the levee is non-project. Therefore, the rating was given A/W.

View of an erosion on the waterside shoulder of the levee.

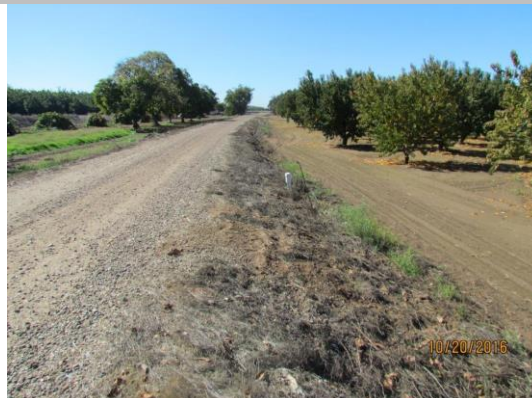
Photo 1 of 2 : FA\_2018\_NA0017\_159\_140\_20181001\_00078.jpg

LM Start	6.67	Rating **	A/W	Issue No.	140
LM End	6.67	Issue Type +	Ma	Location *	LS
Category	Earthen Levee			GPS Latitude/Longitude	
				Start	End
Item	Animal Control			37.983817 °	37.983817 °
				-121.091141 °	-121.091141 °
DWR ID	DWR_NA0017_15_f_2015_140				
Comment Code					
A3 : No rodents visible, but rodent burrows visible; need to backfill and compact or grout burrows.					
Inspector Comment					
This portion of the levee is non-project. Therefore, the rating was given as A/W.

Updated picture of the rodent holes on the landside of the levee. Fall 2016

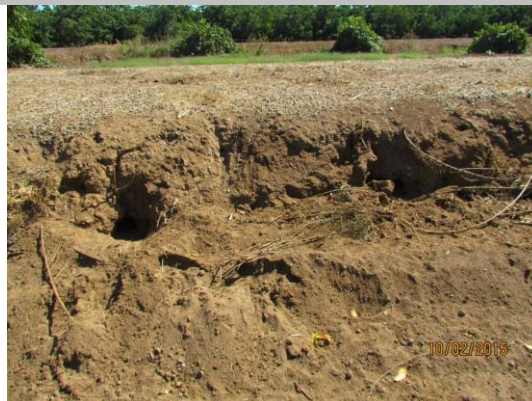
Photo 2 of 2 : FA\_2018\_NA0017\_159\_140\_20181001\_00079.jpg

LM Start	<b>6.67</b>	Rating **	A/W	Issue No.	<b>140 (cont)</b>
LM End	<b>6.67</b>	Issue Type +	Ma	Location *	LS

Rodent holes were found on the landside shoulder of the levee looking downstream.

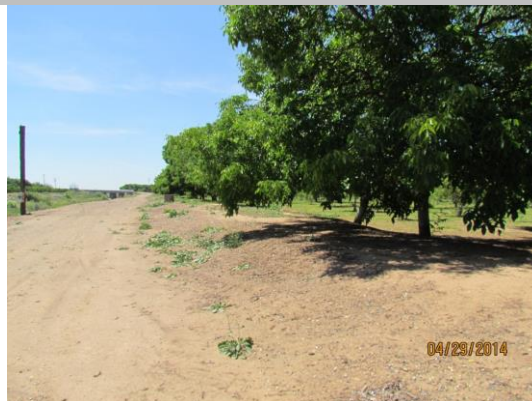
Photo 1 of 1 : FA\_2018\_NA0017\_159\_115\_20181001\_00071.jpg

LM Start	6.96	Rating **	A/W	Issue No.	115
LM End	7.40	Issue Type +	Ma	Location *	LS
Category	Earthen Levee			GPS Latitude/Longitude	
				Start	End
Item	Trim / Thin Trees			37.981387 °	37.978463 °
				-121.095370 °	-121.102252 °
DWR ID	DWR_NA0017_15_s_2014_115				
Comment Code					
T1 : Trim trees to at least five feet above ground level.					
Inspector Comment					
Trees branches were obstructing the access/patrol road.

Tree limbs were obstructing the visibility of the crown of the levee looking downstream.

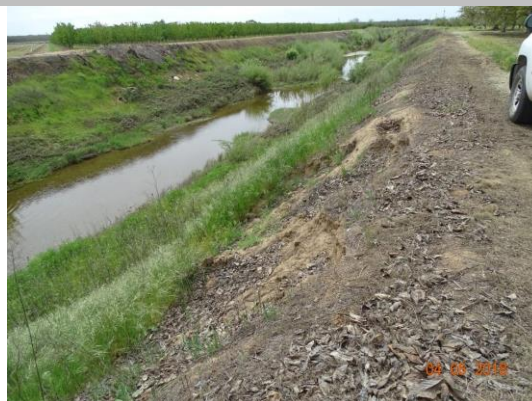
Photo 1 of 2 : FA\_2018\_NA0017\_159\_162\_20181001\_00099.jpg

LM Start	7.67	Rating **	A/W	Issue No.	162
LM End	7.67	Issue Type +	Ma	Location *	LS
Category	Earthen Levee			GPS Latitude/Longitude	
				Start	End
Item	Slope Stability			37.976275 °	37.976275 °
				-121.106364 °	-121.106364 °
DWR ID	DWR_NA0017_15_f_2017_162				
Comment Code					
S1 : Repair slope instability.					
Inspector Comment					
This portion of the levee is non-project. Therefore, the rating was given A/W.

Erosion waterside looking east.

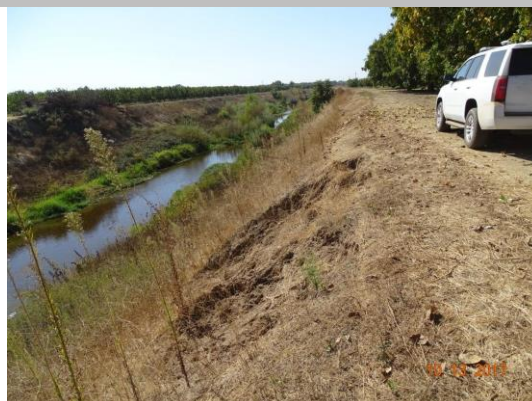
Photo 2 of 2 : FA\_2018\_NA0017\_159\_162\_20181001\_00100.jpg

View of slope instability on the waterside slope of the levee looking downstream. Fall 2017

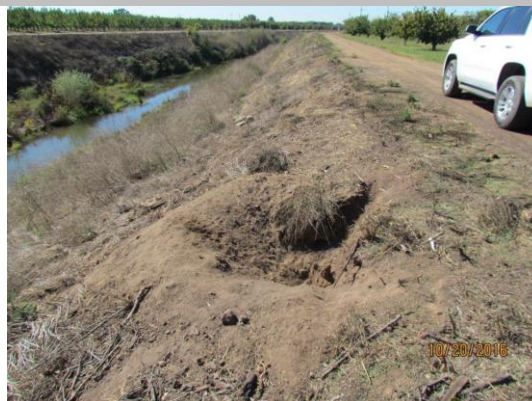
Photo 1 of 1 : FA\_2018\_NA0017\_159\_84\_20181001\_00061.jpg

LM Start	7.73	Rating **	M	Issue No.	84
LM End	7.73	Issue Type +	Ma	Location *	WS
Category	Earthen Levee			GPS Latitude/Longitude	
				Start	End
Item	Animal Control			37.975679 °	37.975679 °
				-121.107246 °	-121.107246 °
DWR ID	DWR_NA0017_15_f_2016_84				
Comment Code					
A3 : No rodents visible, but rodent burrows visible; need to backfill and compact or grout burrows.					
Inspector Comment					
Rodent hole on the shoulder of the waterside of the levee. It might cut into the access road in future.

View of a rodent hole on the waterside of the levee looking downstream. Fall 2016

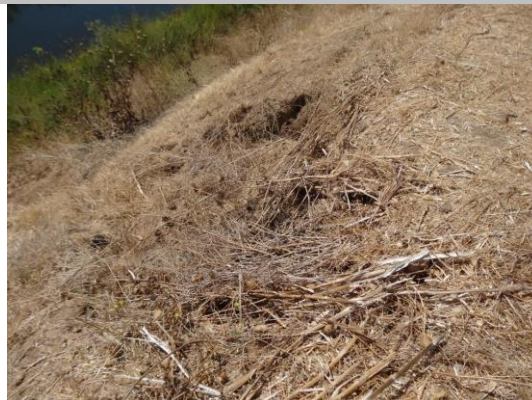
Photo 3 of 3 : FA\_2018\_NA0017\_159\_5\_20181001\_00009.jpg

LM Start	8.43	Rating **	M	Issue No.	5 (cont)	
LM End	8.43	Issue Type +	Ma	Location *	WS	
Category	Supplemental			GPS Latitude/Longitude		
				Start	End	
Item	DWR Erosion Survey			37.969711 °	37.969711 °	
				-121.116739 °	-121.116739 °	
DWR ID	NA0017U15RM14.49					
Comment Code						
Inspector Comment						
08/30/2017: No significant change observed.						
08/16/2016: The erosion was not visible due to dense vegetation at the site.						
08/12/2015: No significant change observed. More vegetation is observed at the site.						
08/20/2014: No significant change observed.						
09/12/2013: The erosion has been caused by runoff. [2017 Site ID:NA0017U15RM14.49]

Close view of the erosion site.

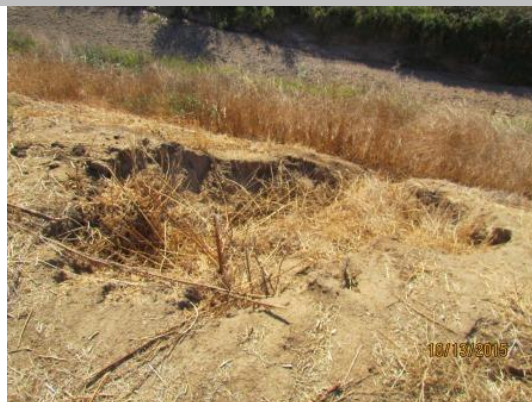
Photo 1 of 2 : FA\_2018\_NA0017\_159\_65\_20181001\_00050.jpg

LM Start	8.43	Rating **	A/W	Issue No.	65
LM End	8.43	Issue Type +	Ma	Location *	WS
Category	Earthen Levee			GPS Latitude/Longitude	
				Start	End
Item	Erosion / Bank Caving			37.969699 °	37.969699 °
				-121.116796 °	-121.116796 °
DWR ID	DWR_NA0017_15_f_2018_65				
Comment Code					
E2 : Schedule repair of erosion site prior to the next inspection.					
Inspector Comment					
Repair erosion site before it impacts patrol road.

Updated picture of the slope instability on the waterside of the levee looking upstream during fall 2015 inspection.

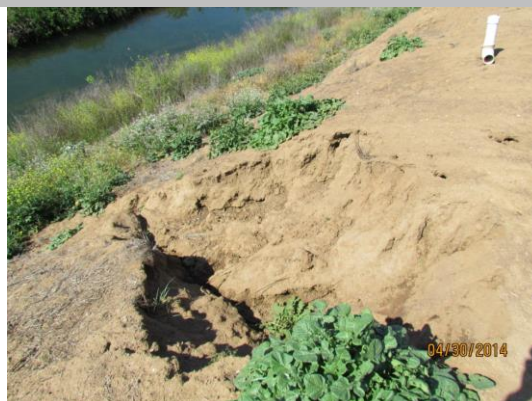
Photo 2 of 2 : FA\_2018\_NA0017\_159\_65\_20181001\_00051.jpg

LM Start	8.43	Rating **	A/W	Issue No.	65 (cont)	
LM End	8.43	Issue Type +	Ma	Location *	WS	
Category	Earthen Levee			GPS Latitude/Longitude		
				Start		End
Item	Erosion / Bank Caving			37.969699 °	37.969699 °	
				-121.116796 °	-121.116796 °	
DWR ID	DWR_NA0017_15_f_2018_65					
Comment Code						
E2 : Schedule repair of erosion site prior to the next inspection.						
Inspector Comment						
Repair erosion site before it impacts patrol road.

View of the slope instability on the waterside of the levee looking downstream during spring 2014 inspection.

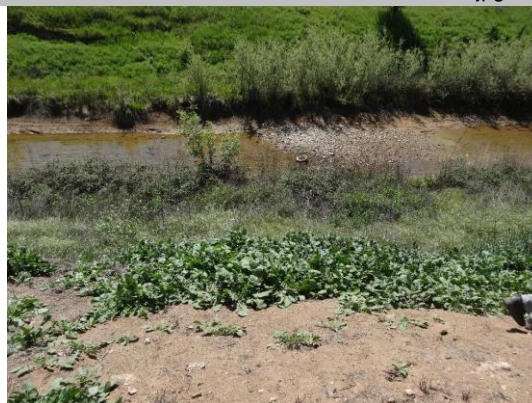
Photo 1 of 3 : UCIP\_FA\_2018\_40386\_63765.jpg

LM Start	8.46	Rating **	M	Issue No.	1175	
LM End	8.46	Issue Type +	Ma	Location *		
Category	Supplemental			GPS Latitude/Longitude		
				Start	End	
Item	DWR UCIP LMA Responsibility			37.969690 °	37.969690 °	
				-121.117404 °	-121.117404 °	
DWR ID	23227					
Comment Code						
Inspector Comment						
FS_ID:40386						
DS_ID:23227						
EP_NO: N/A						
Repair Type: Non-Urgent						
Crossing Status: Found						
UCIP Comments: Distorted inlet pipe opening on landside. No pipe found on waterside. Dense vegetation and steep slope on waterside.						
FIELD_STRUCT_DESC: 18-inch CM pipe through the levee, 1.0 feet below the crown. O&M Manual SJR Assumed 999.						
FS Date: 4/10/2014

WS view: no pipe or appurtenances found on waterside. Dense vegetation.
