**Flood Control Project Maintenance  
Levee Inspections**

**Maintenance Issue Types Only, Levee Inspection Report By Mile - Fall 2018**

**San Joaquin County Flood Control and Water Conservation District**

Waterway	Bank	Unit Miles	Inspection Start/End	Inspector
Unit No. 01 Littlejohn Creek	Left	2.59	10/18/2018 10/18/2018	Wade Wylie

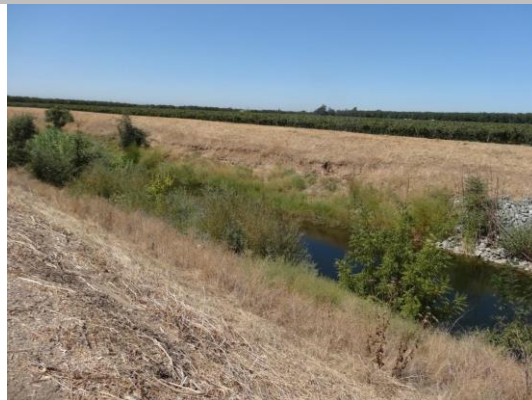
Photo 1 of 4 : FA\_2018\_NA0017\_159\_4\_20181001\_00003.jpg

LM Start	8.81	Rating **	M	Issue No.	4
LM End	8.83	Issue Type +	Ma	Location *	WS
Category	Supplemental			GPS Latitude/Longitude	
				Start	End
Item	DWR Erosion Survey			37.968060 °	37.968060 °
				-121.123299 °	-121.123299 °
DWR ID	NA0017U15RM13.87				
Comment Code					
Inspector Comment					
08/30/2017: No significant change observed.					
08/16/2016: No significant change observed.					
08/12/2015: No significant change observed.					
08/20/2014: Both ends of the erosion site are protected by riprap. [2017					
Site ID:NA0017U15RM13.87]

View of the site from left river bank.

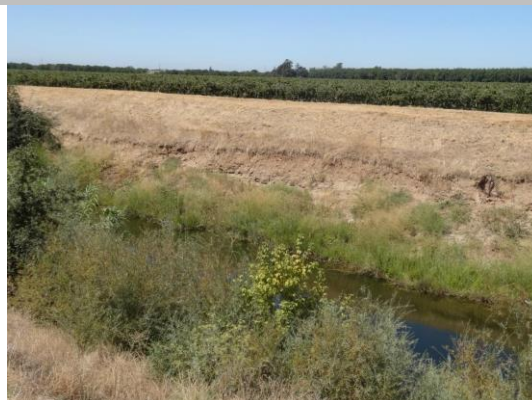
Photo 2 of 4 : FA\_2018\_NA0017\_159\_4\_20181001\_00004.jpg

Close view of the erosion.

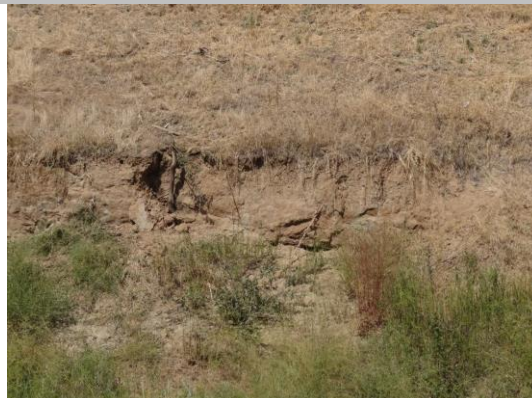
Photo 3 of 4 : FA\_2018\_NA0017\_159\_4\_20181001\_00005.jpg

Close view of the erosion.

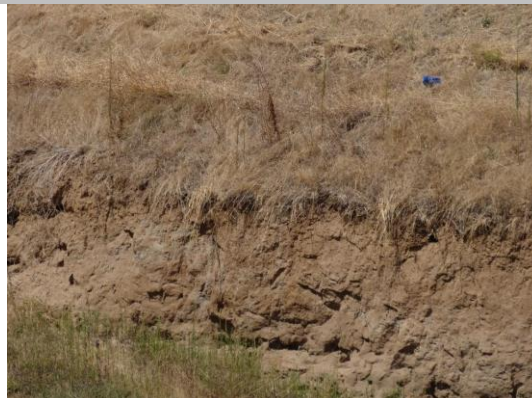
Photo 4 of 4 : FA\_2018\_NA0017\_159\_4\_20181001\_00006.jpg

LM Start	8.81	Rating **	M	Issue No.	4 (cont)	
LM End	8.83	Issue Type +	Ma	Location *	WS	
Category	Supplemental			GPS Latitude/Longitude		
				Start		End
Item	DWR Erosion Survey			37.968060 °		37.968060 °
				-121.123299 °		-121.123299 °
DWR ID	NA0017U15RM13.87					
Comment Code						
Inspector Comment						
08/30/2017: No significant change observed.						
08/16/2016: No significant change observed.						
08/12/2015: No significant change observed.						
08/20/2014: Both ends of the erosion site are protected by riprap. [2017						
Site ID:NA0017U15RM13.87]

Close view of the erosion.

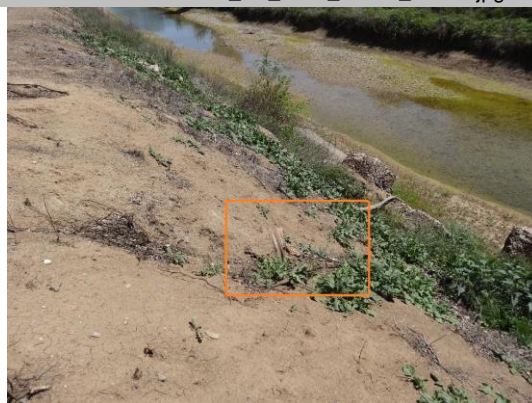
Photo 1 of 3 : UCIP\_FA\_2018\_34983\_62966.jpg

LM Start	9.55	Rating **	M	Issue No.	1178	
LM End	9.55	Issue Type +	Ma	Location *		
Category	Supplemental			GPS Latitude/Longitude		
				Start	End	
Item	DWR UCIP LMA Responsibility			37.966327 °	37.966327 °	
				-121.135980 °	-121.135980 °	
DWR ID	23233					
Comment Code						
Inspector Comment						
FS_ID:34983 DS_ID:23233 EP_NO: N/A Repair Type: Non-Urgent Crossing Status: Found UCIP Comments: Needs clearing and cleaning of the pipe. FIELD_STRUCT_DESC: 18-inch corrugated metal drainage pipe through the levee, 3.5 feet below the crown. Pipe discharges onto waterside (WS) slope. Slope eroding. [Additional Reference(s): DWR Levee Log, 1992. USACE San Joaquin O&M Manual 611.1, Volume F, (HLM 9.75)]. FS Date: 4/10/2014

WS view: CM outlet pipe on levee slope.

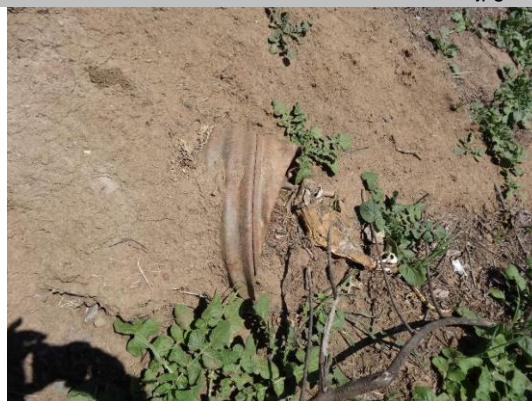
Photo 2 of 3 : UCIP\_FA\_2018\_34983\_62965.jpg

WS view: CM outlet pipe on levee slope.

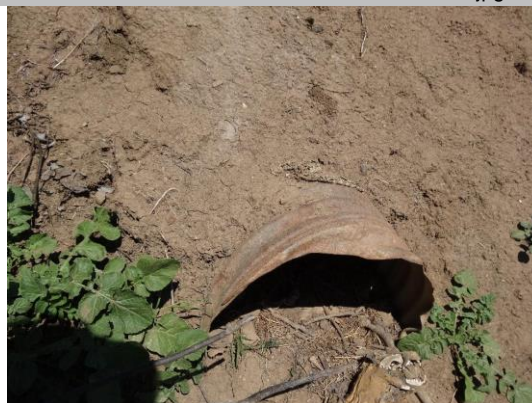
Photo 3 of 3 : UCIP\_FA\_2018\_34983\_62964.jpg

WS view: closer view of CM outlet pipe on levee slope.

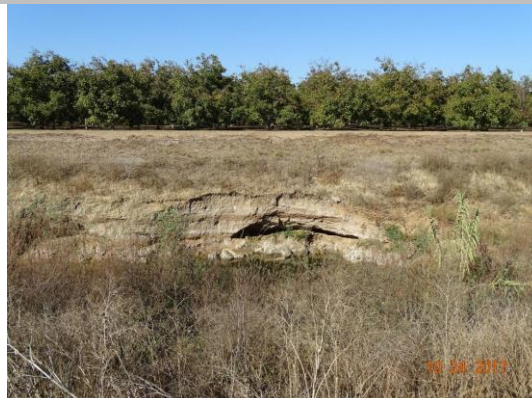
Photo 1 of 1 : FA\_2018\_NA0017\_159\_183\_20181001\_00110.jpg

LM Start	9.62	Rating **	A/W	Issue No.	183
LM End	9.62	Issue Type +	Ma	Location *	WS
Category	Earthen Levee			GPS Latitude/Longitude	
				Start	End
Item	Erosion / Bank Caving			37.965693 °	37.965693 °
				-121.137063 °	-121.137063 °
DWR ID	DWR_NA0017_15_f_2017_183				
Comment Code					
E1 : Note and monitor erosion site.					
Inspector Comment					
Erosion was found on the waterside toe of the levee. It possibly could be a beaver den at this location.

View of an erosion with a possible beaver den on the waterside toe of the levee. The picture was taken from the opposite side of the levee. Fall 2017

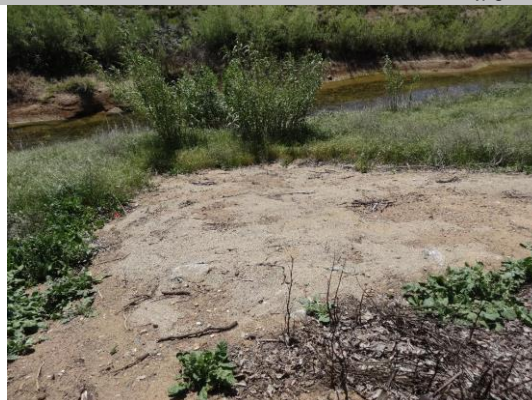
Photo 1 of 3 : UCIP\_FA\_2018\_34986\_62986.jpg

LM Start	9.80	Rating **	M	Issue No.	1181	
LM End	9.80	Issue Type +	Ma	Location *		
Category	Supplemental			GPS Latitude/Longitude		
				Start	End	
Item	DWR UCIP LMA Responsibility			37.965294 °	37.965294 °	
				-121.140184 °	-121.140184 °	
DWR ID	23235					
Comment Code						
Inspector Comment						
FS_ID:34986 DS_ID:23235 EP_NO: N/A Repair Type: Non-Urgent Crossing Status: Found UCIP Comments: Mud/soil in inlet pipe. Needs cleaning.No pipe or appurtenances visible on waterside. Dense vegetation (may be visible from other channel bank). FIELD_STRUCT_DESC: 18-inch corrugated metal drainage pipe through the levee, 4 feet below the crown. Grouted inlet and outlet. [Additional Reference(s): DWR Levee Log, 1992. USACE San Joaquin O&M Manual 611.1, Volume F, (HLM 10.01)]. FS Date: 4/10/2014

WS view: no pipe or appurtenances found.

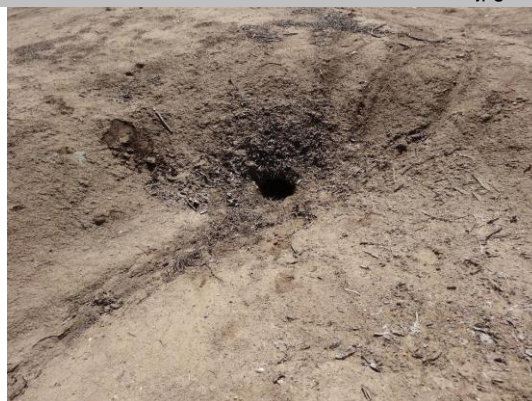
Photo 2 of 3 : UCIP\_FA\_2018\_34986\_62985.jpg

LS view: partially buried inlet pipe.

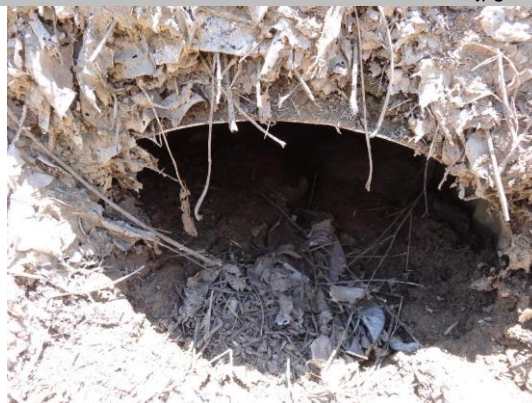
Photo 3 of 3 : UCIP\_FA\_2018\_34986\_62984.jpg

LS view: closer view of partially buried inlet pipe. Needs cleaning and clearing.

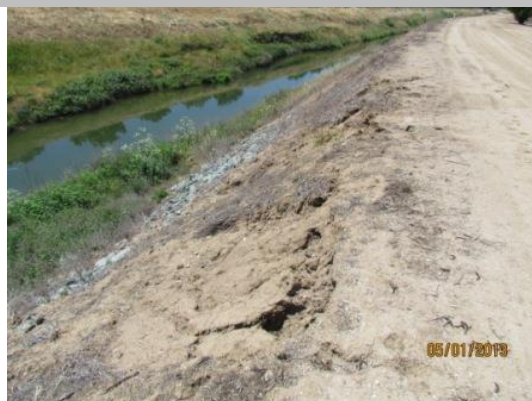
Photo 1 of 1 : FA\_2018\_NA0017\_159\_68\_20181001\_00054.jpg

LM Start	9.90	Rating **	A/W	Issue No.	68
LM End	9.90	Issue Type +	Ma	Location *	WS
Category	Earthen Levee			GPS Latitude/Longitude	
				Start	End
Item	Slope Stability			37.965165°	37.965165°
				-121.141928°	-121.141928°
DWR ID	DWR_NA0017_15_s_2013_68				
Comment Code					
S1 : Repair slope instability.					
Inspector Comment					
This portion of the levee is non-project. Therefore, the rating was given as A/W.

Slope instability was found on the waterside slope of the levee looking downstream.

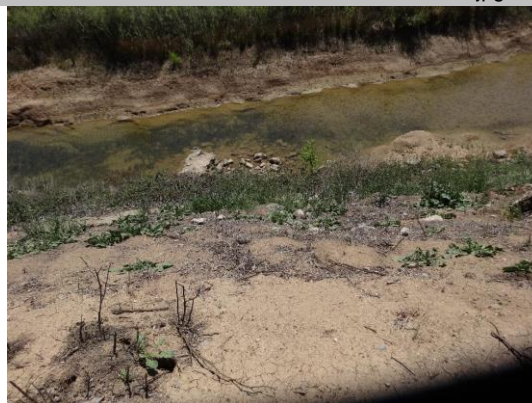
Photo 1 of 3 : UCIP\_FA\_2018\_34987\_62992.jpg

LM Start	10.01	Rating **	M	Issue No.	1182
LM End	10.01	Issue Type +	Ma	Location *	
Category	Supplemental			GPS Latitude/Longitude	
				Start	End
Item	DWR UCIP LMA Responsibility			37.965085 °	37.965085 °
				-121.143999 °	-121.143999 °
DWR ID	23236				
Comment Code					
Inspector Comment					
FS_ID:34987					
DS_ID:23236					
EP_NO: N/A					
Repair Type: Non-Urgent					
Crossing Status: Found					
UCIP Comments: May need cleaning of the pipe.Pipe not visible on waterside.					
FIELD_STRUCT_DESC: 18-inch corrugated metal drainage pipe through the levee, 4.5 feet below the crown. Grouted inlet and outlet.					
[Additional Reference(s): DWR Levee Log, 1992. USACE San Joaquin O&M Manual 611.1, Volume F, (HLM 10.22)].					
FS Date: 4/10/2014

WS view: no pipe or appurtenances found.

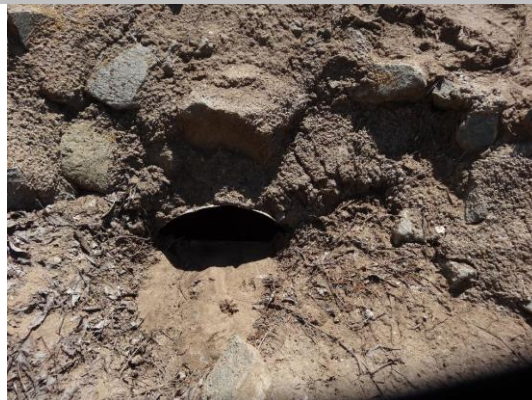
Photo 2 of 3 : UCIP\_FA\_2018\_34987\_62990.jpg

FS\_ID:34987  
DS\_ID:23236  
EP\_NO: N/A  
Repair Type: Non-Urgent  
Crossing Status: Found  
UCIP Comments: May need cleaning of the pipe. Pipe not visible on waterside.  
FIELD\_STRUCT\_DESC: 18-inch corrugated metal drainage pipe through the levee, 4.5 feet below the crown. Grouted inlet and outlet.  
[Additional Reference(s): DWR Levee Log, 1992. USACE San Joaquin O&M Manual 611.1, Volume F, (HLM 10.22)].  
FS Date: 4/10/2014

LS view: partially buried inlet pipe on levee toe.

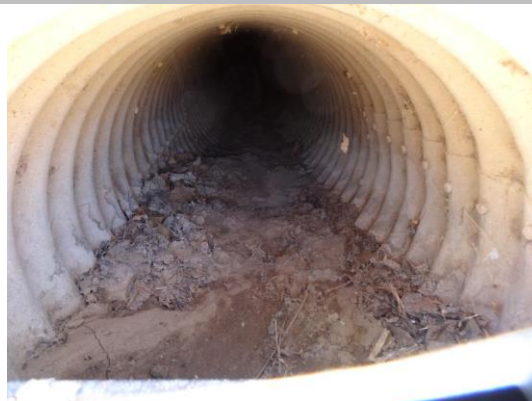
Photo 3 of 3 : UCIP\_FA\_2018\_34987\_62991.jpg

LS view: inside view of partially buried inlet pipe. Needs cleaning.

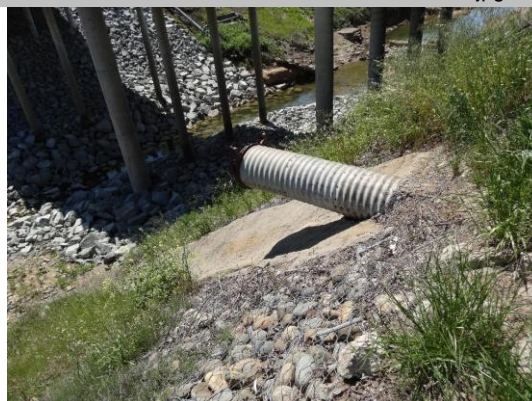
Photo 1 of 2 : UCIP\_FA\_2018\_35003\_63003.jpg

LM Start	10.26	Rating **	A/W	Issue No.	1183	
LM End	10.26	Issue Type +	Ma	Location *		
Category	Supplemental			GPS Latitude/Longitude		
				Start		End
Item	DWR UCIP LMA Responsibility			37.965104 °		37.965104 °
				-121.148460 °		-121.148460 °
DWR ID	23237					
Comment Code						
Inspector Comment						
FS_ID:35003 DS_ID:23237 EP_NO: N/A Repair Type: No Action Needed Crossing Status: Found UCIP Comments: May need cleaning of the inlet pipe. Vegetation debris on inlet box. FIELD_STRUCT_DESC: 18-inch corrugated metal drainage pipe through the levee, 7.5 feet below the crown. Concrete U-shaped headwall on the landside (LS). Flap gate on the waterside (WS). [Additional Reference(s): DWR Levee Log, 1992. USACE San Joaquin O&M Manual 611.1, Volume F, (HLM 10.47)]. FS Date: 4/10/2014

WS view: CM outfall pipe with flapgate on levee slope.

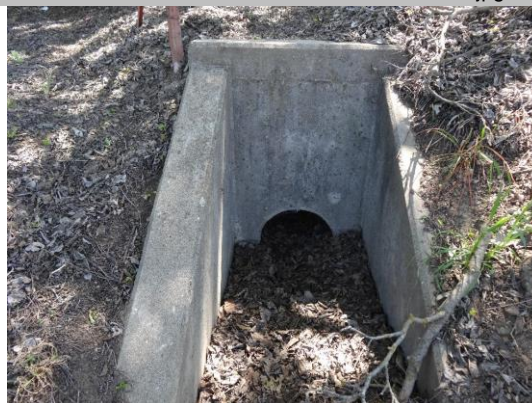
Photo 2 of 2 : UCIP\_FA\_2018\_35003\_63002.jpg

LS view: concrete headwall and inlet pipe. Needs cleaning of debris.

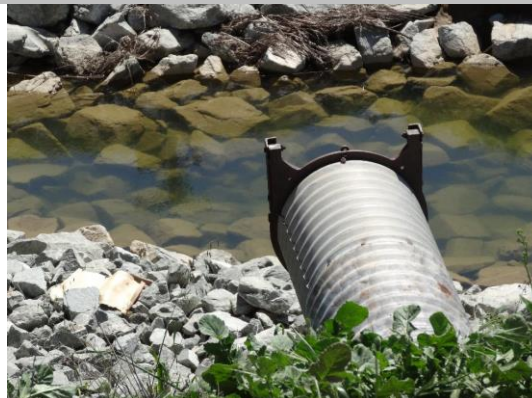
Photo 1 of 2 : UCIP\_FA\_2018\_35005\_63011.jpg

LM Start	10.27	Rating **	M	Issue No.	1185	
LM End	10.27	Issue Type +	Ma	Location *		
Category	Supplemental			GPS Latitude/Longitude		
				Start	End	
Item	DWR UCIP LMA Responsibility			37.965097 °	37.965097 °	
				-121.148671 °	-121.148671 °	
DWR ID	23238					
Comment Code						
Inspector Comment						
FS_ID:35005						
DS_ID:23238						
EP_NO: N/A						
Repair Type: Non-Urgent						
Crossing Status: Found						
UCIP Comments: Pipe buried on landside. May need cleaning of vegetation debris in inlet opening.						
FIELD_STRUCT_DESC: 18-inch corrugated metal drainage pipe through the levee, 7.5 feet below the crown. Flap gate on the waterside (WS). [Additional Reference(s): DWR Levee Log, 1992. USACE San Joaquin O&M Manual 611.1, Volume F, (HLM 10.49)].						
FS Date: 4/10/2014

WS view: CM outfall pipe with flapgate on levee slope.

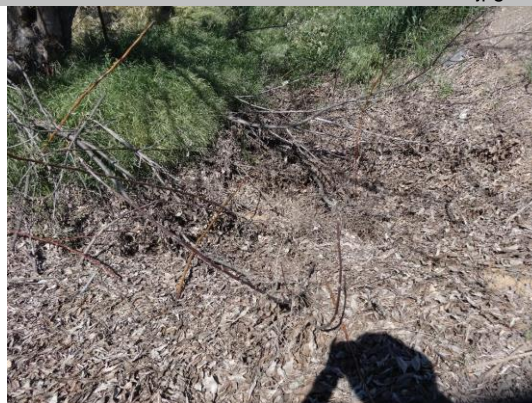
Photo 2 of 2 : UCIP\_FA\_2018\_35005\_63010.jpg

LS view: vegetation debris in inlet area. Needs cleaning and clearing.

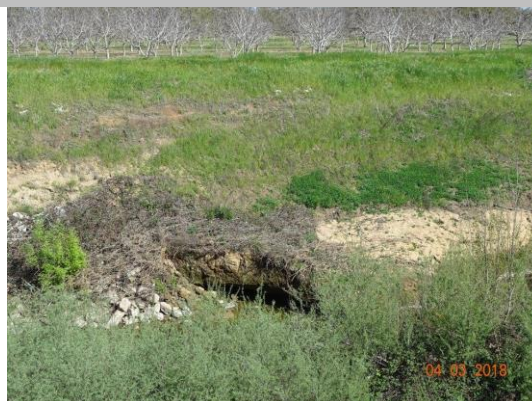
Photo 1 of 1 : FA\_2018\_NA0017\_159\_143\_20181001\_00080.jpg

LM Start	10.75	Rating **	U	Issue No.	143
LM End	10.75	Issue Type +	Ma	Location *	WS
Category	Earthen Levee			GPS Latitude/Longitude	
				Start	End
Item	Erosion / Bank Caving			37.963449 °	37.963449 °
				-121.157018 °	-121.157018 °
DWR ID	DWR_NA0017_15_s_2018_143				
Comment Code					
E2 : Schedule repair of erosion site prior to the next inspection.					
Inspector Comment					
This is non-project levee patrol road. Erosion could potentially impact patrol road.

Erosion bank caving waterside taken from opposite bank looking north.

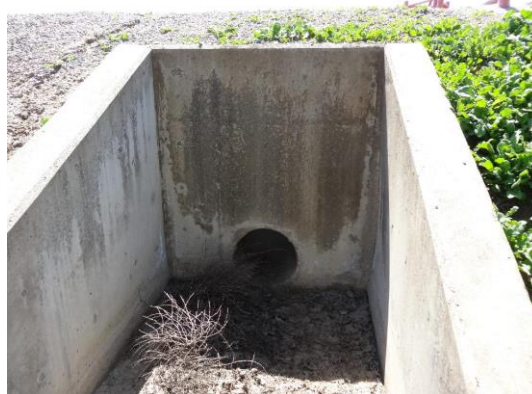
Photo 2 of 2 : UCIP\_FA\_2018\_35010\_63034.jpg

LS view: headwall and inlet pipe on levee toe.

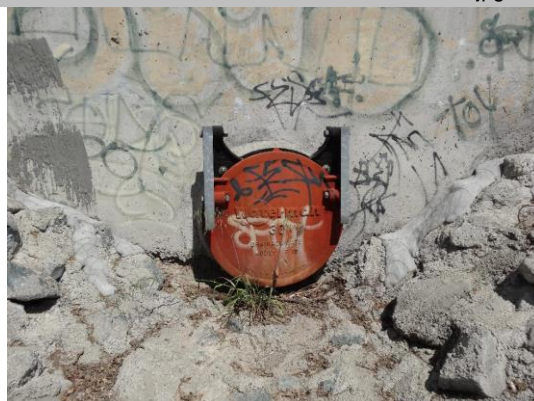
Photo 1 of 2 : UCIP\_FA\_2018\_48304\_63039.jpg

LM Start	11.55	Rating **	A/W	Issue No.	1188	
LM End	11.55	Issue Type +	Ma	Location *		
Category	Supplemental			GPS Latitude/Longitude		
				Start		End
Item	DWR UCIP LMA Responsibility			37.960961 °		37.960961 °
				-121.170662 °		-121.170662 °
DWR ID	23244					
Comment Code						
Inspector Comment						
FS_ID:48304						
DS_ID:23244						
EP_NO: N/A						
Repair Type: No Action Needed						
Crossing Status: Found						
UCIP Comments: New pipe and flapgate.						
FIELD_STRUCT_DESC: 30-inch corrugated metal drainage pipe						
through the levee, 4.5 feet below the crown. Flap gate on the waterside						
(WS). Headwall with open inlet pipe on the landside (LS). Grouted						
outlet. [Additional Reference(s): DWR Levee Log, 1992, 18-inch pipe						
listed. USACE San Joaquin O&M Manual 611.1, Volume F, (HLM						
11.79) 18-inch pipe listed].						
FS Date: 4/14/2014

WS view: outlet CM pipe with flapgate. Flood wall acts as headwall.

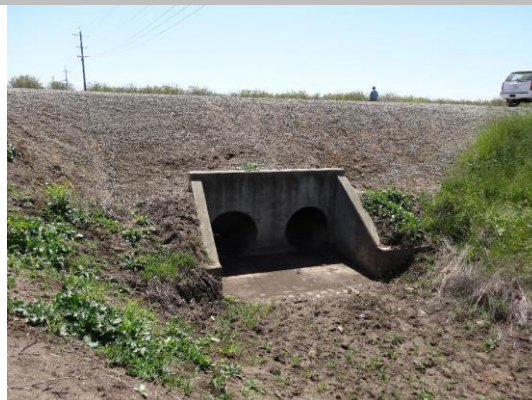
Photo 3 of 3 : UCIP\_FA\_2018\_35015\_63057.jpg

LM Start	12.39	Rating **	A/W	Issue No.	1190 (cont)	
LM End	12.39	Issue Type +	Ma	Location *		
Category	Supplemental			GPS Latitude/Longitude		
				Start	End	
Item	DWR UCIP LMA Responsibility			37.961205 °	37.961205 °	
				-121.185839 °	-121.185839 °	
DWR ID	23454					
Comment Code						
Inspector Comment						
FS_ID:35015 DS_ID:23454 EP_NO: N/A Repair Type: No Action Needed Crossing Status: Found UCIP Comments: May need mud and debris cleaning. FIELD_STRUCT_DESC: 2 of 2: 48-inch drainage pipe of an unknown material through the levee, 11.5 feet below the crown. Slide gate in corrugated metal riser units on the waterside (WS) slope. Concrete U-shaped headwall on both ends. Flap gates. Grouted rock spillway. [Additional Reference(s): DWR Levee Log, 1992. USACE San Joaquin O&M Manual 611.1, Volume F, (HLM 12.65) corrugated metal pipe listed]. FS Date: 4/14/2014

LS view: headwall and inlet pipes on levee slope.

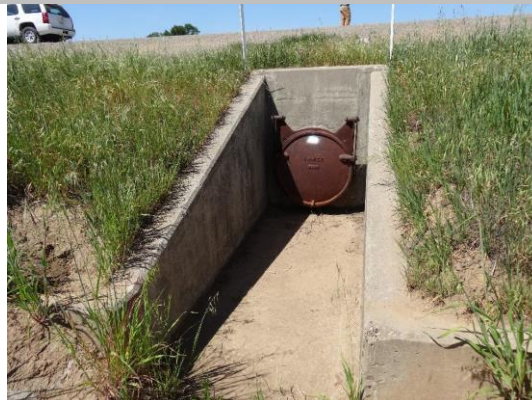
Photo 1 of 3 : UCIP\_FA\_2018\_35047\_63100.jpg

LM Start	13.15	Rating **	M	Issue No.	1195
LM End	13.15	Issue Type +	Ma	Location *	
Category	Supplemental			GPS Latitude/Longitude	
				Start	End
Item	DWR UCIP LMA Responsibility			37.961186 °	37.961186 °
				-121.199150 °	-121.199150 °
DWR ID	23252				
Comment Code					
Inspector Comment					
FS_ID:35047					
DS_ID:23252					
EP_NO: N/A					
Repair Type: Non-Urgent					
Crossing Status: Found					
UCIP Comments: Needs pipe cleaning.					
FIELD_STRUCT_DESC: 30-inch corrugated metal drainage pipe through the levee, 8.5 feet below the crown. Concrete U-shaped headwalls on both ends. Grouted spillway on the waterside (WS). Flap gate on the WS end. [Additional Reference(s): DWR Levee Log, 1992. USACE San Joaquin O&M Manual 611.1, Volume F, (HLM 13.43)].					
FS Date: 4/14/2014

WS view: U type concrete headwall, CM pipe with flapgate, and concrete spillway on levee slope.

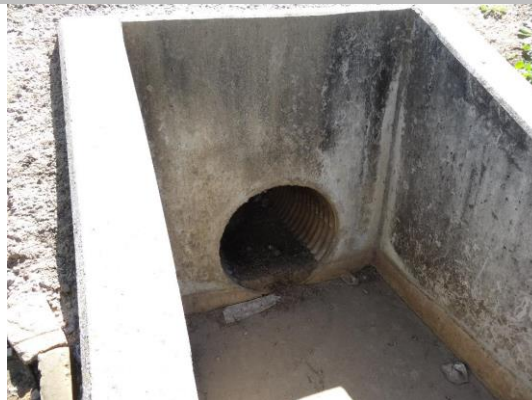
Photo 2 of 3 : UCIP\_FA\_2018\_35047\_63099.jpg

FS\_ID:35047  
DS\_ID:23252  
EP\_NO: N/A  
Repair Type: Non-Urgent  
Crossing Status: Found  
UCIP Comments: Needs pipe cleaning.  
FIELD\_STRUCT\_DESC: 30-inch corrugated metal drainage pipe through the levee, 8.5 feet below the crown. Concrete U-shaped headwalls on both ends. Grouted spillway on the waterside (WS). Flap gate on the WS end. [Additional Reference(s): DWR Levee Log, 1992. USACE San Joaquin O&M Manual 611.1, Volume F, (HLM 13.43)].  
FS Date: 4/14/2014

LS view: U type concrete headwall and CM inlet Pipe on levee slope.  
Soil/mud on inlet box.

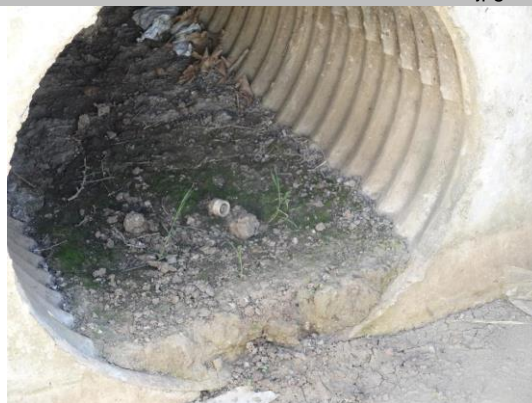
Photo 3 of 3 : UCIP\_FA\_2018\_35047\_63101.jpg

LS view: inside view of the CM pipe. Needs cleaning and clearing the pipe.

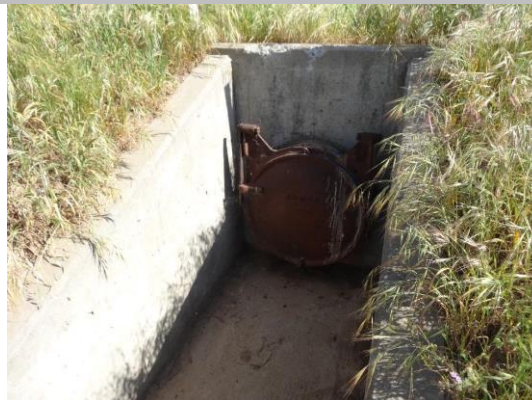
Photo 1 of 3 : UCIP\_FA\_2018\_35104\_63192.jpg

LM Start	15.28	Rating **	A/W	Issue No.	1201
LM End	15.28	Issue Type +	Ma	Location *	
Category	Supplemental			GPS Latitude/Longitude	
				Start	End
Item	DWR UCIP LMA Responsibility			37.975060 °	37.975060 °
				-121.232719 °	-121.232719 °
DWR ID	23188				
Comment Code					
Inspector Comment					
FS_ID:35104					
DS_ID:23188					
EP_NO: N/A					
Repair Type: No Action Needed					
Crossing Status: Found					
UCIP Comments: May need cleaning.					
FIELD_STRUCT_DESC: 30-inch corrugated metal drainage pipe through the levee, 9.5 feet below the crown. Concrete U-shaped headwall on both ends. Grouted spillway and intake. Flap gate on the waterside (WS). [Additional Reference(s): DWR Levee Log, 1992. USACE San Joaquin O&M Manual 611.1, Volume F, (HLM 15.58)].					
FS Date: 4/15/2014

WS view: U type concrete headwall, CM pipe with flapgate, and concrete spillway on levee slope.

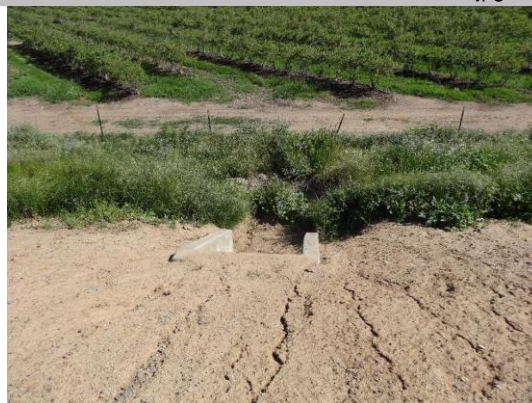
Photo 2 of 3 : UCIP\_FA\_2018\_35104\_63191.jpg

LS view: U type concrete headwall on levee slope.

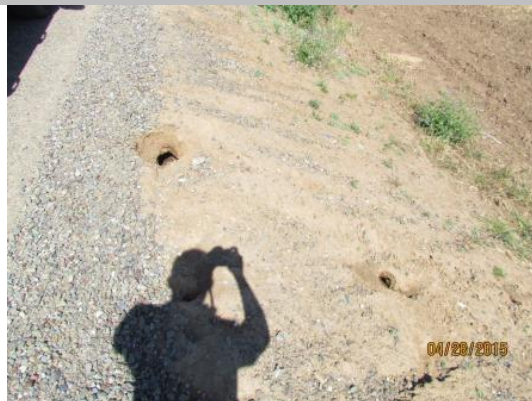
Photo 2 of 2 : FA\_2018\_NA0017\_159\_194\_20181001\_00118.jpg

Rodent holes were found on the landside of the levee looking downstream.

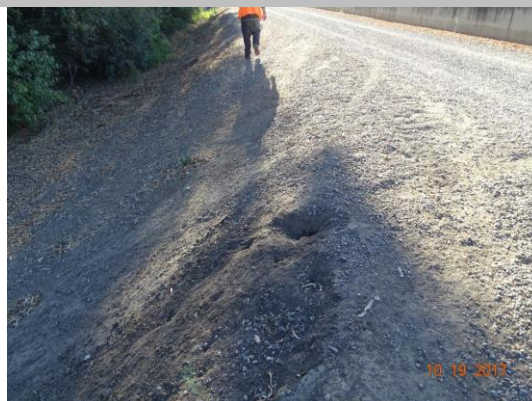
Photo 1 of 1 : FA\_2018\_NA0017\_159\_166\_20181001\_00102.jpg

LM Start	15.55	Rating **	M	Issue No.	166
LM End	15.55	Issue Type +	Ma	Location *	LS
Category	Earthen Levee			GPS Latitude/Longitude	
				Start	End
Item	Animal Control			37.976812 °	37.976812 °
				-121.237096 °	-121.237096 °
DWR ID	DWR_NA0017_15_s_2018_166				
Comment Code					
A3 : No rodents visible, but rodent burrows visible; need to backfill and compact or grout burrows.					
Inspector Comment

View of a rodent hole on the landside shoulder of the levee looking upstream. Fall 2017

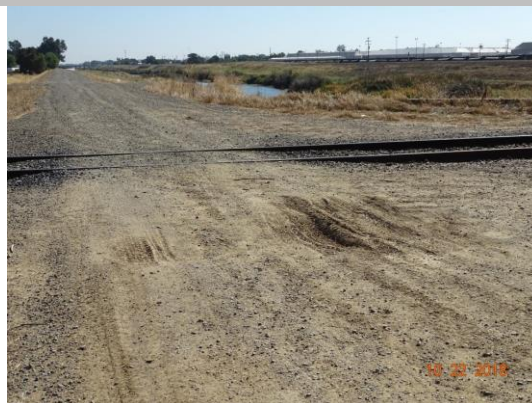
Photo 1 of 1 : FA\_2018\_NA0017\_159\_197\_20181024\_00162.jpg

LM Start	16.00	Rating **	M	Issue No.	197
LM End	16.00	Issue Type +	Ma	Location *	CR
Category	Earthen Levee			GPS Latitude/Longitude	
				Start	End
Item	Crown Surface / Depressions / Rutting			37.980052 °	37.980052 °
				-121.244213 °	-121.244213 °
DWR ID	DWR_NA0017_15_f_2018_197				
Comment Code					
C2 : Repair depressions or ruts in the crown or slope.					
Inspector Comment

View of rut on the access road (October 2018).

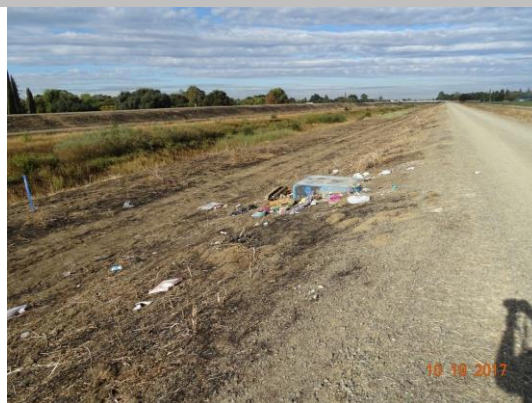
Photo 1 of 1 : FA\_2018\_NA0017\_159\_169\_20181001\_00103.jpg

LM Start	16.94	Rating **	A/W	Issue No.	169
LM End	16.94	Issue Type +	Ma	Location *	WS
Category	Earthen Levee			GPS Latitude/Longitude	
				Start	End
Item	Encroachments			37.986367 °	37.986367 °
				-121.259337 °	-121.259337 °
DWR ID	DWR_NA0017_15_f_2017_169				
Comment Code					
DE : Debris					
Inspector Comment

View of debris on the waterside slope of the levee. Fall 2017

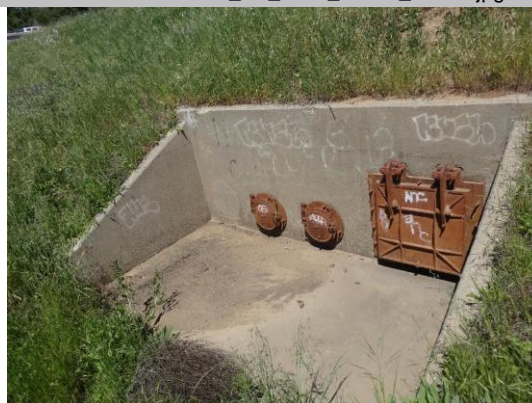
Photo 2 of 3 : UCIP\_FA\_2018\_35163\_63284.jpg

WS view: U type concrete headwall, 14" CM pipes and 30" RC culvert with flapgate, and concrete spillway on levee slope.

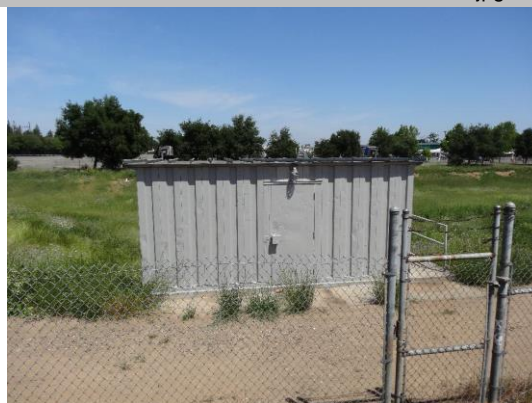
Photo 3 of 3 : UCIP\_FA\_2018\_35163\_63283.jpg

Comment Code					
Inspector Comment					
FS_ID:35163 DS_ID:23265 EP_NO: N/A Repair Type: No Action Needed Crossing Status: Found UCIP Comments: 10/27/2017 This structure is inspected annually under the Structure and Channel Summer Inspection (part of the Levee Inspection Program) conducted by the DWR Flood Project Integrity and Inspection Branch (FPIIB). (DWR UCIP - O. Magana) Adjacent pipes are: two 14-inch pipes through the levee 3.0 feet below the crown. Steel trash rack on landside intake. FIELD_STRUCT_DESC: [Mormon Slough Pumping Plant No. 1] 1 of 3: 30-inch by 30-inch reinforced concrete box drainage culvert through the levee, 17.6 feet below the crown. Slide gate in riser unit on the waterside (WS) slope. Flap gate on the WS end. Concrete U-shaped headwall around all three pipes on the WS. Intake under the pump house on the landside (LS). Steel steps on the LS slope. [Additional Reference(s): DWR Levee Log, 1992. USACE San Joaquin O&M Manual 611.1, Volume F, (HLM 17.74)]. FS Date: 4/15/2014

LS view: pump house inside wired fence on levee slope.

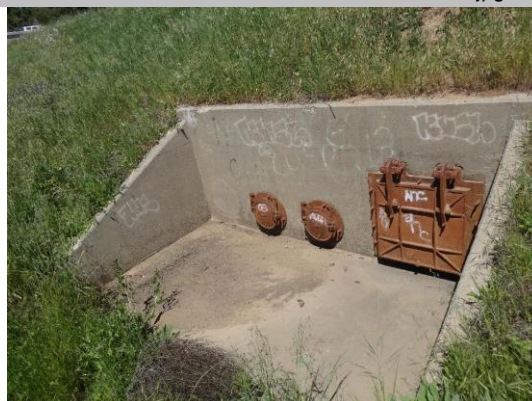
Photo 1 of 2 : UCIP\_FA\_2018\_35164\_63289.jpg

Comment Code					
Inspector Comment					
FS_ID:35164 DS_ID:23460 EP_NO: N/A Repair Type: No Action Needed Crossing Status: Found UCIP Comments: 10/27/2017 This structure is inspected annually under the Structure and Channel Summer Inspection (part of the Levee Inspection Program) conducted by the DWR Flood Project Integrity and Inspection Branch (FPIIB). (DWR UCIP - O. Magana) Adjacent pipe is: 30-inch by 30-inch RC box culvert through the levee 17.6 feet below the crown. Steel trash rack on landside intake. FIELD_STRUCT_DESC: [Mormon Slough Pumping Plant No. 1] 2 of 3: Two 14-inch steel drainage pipes through the levee, 3 feet below the crown. Siphon breakers in 4-foot high riser units on the landside (LS) shoulder. Flap gates on the waterside (WS) end. Concrete U-shaped headwall around all three pipes on the WS. Pump house on the LS. Steel steps on the LS slope. [Additional Reference(s): DWR Levee Log, 1992. USACE San Joaquin O&M Manual 611.1, Volume F, (HLM 17.74)]. FS Date: 4/15/2014

WS view: U type concrete headwall, 14" CM pipes and 30" RC culvert with flapgate, and concrete spillway on levee slope.

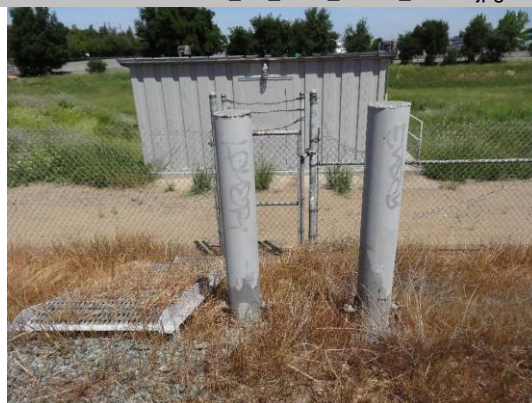
Photo 2 of 2 : UCIP\_FA\_2018\_35164\_63288.jpg

LS view: siphon breakers in steel pipe risers and pump house on levee slope.

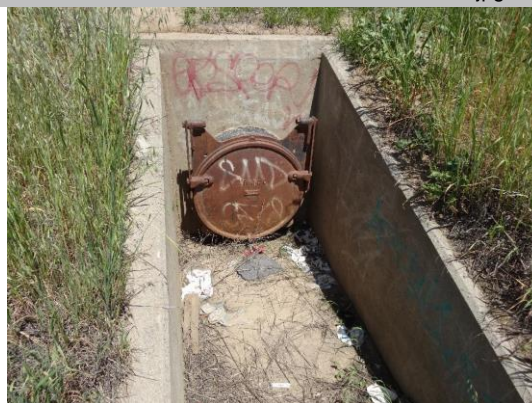
Photo 1 of 3 : UCIP\_FA\_2018\_35183\_63325.jpg

WS view: U type concrete headwall, CM pipe with flapgate, and concrete spillway on levee slope.

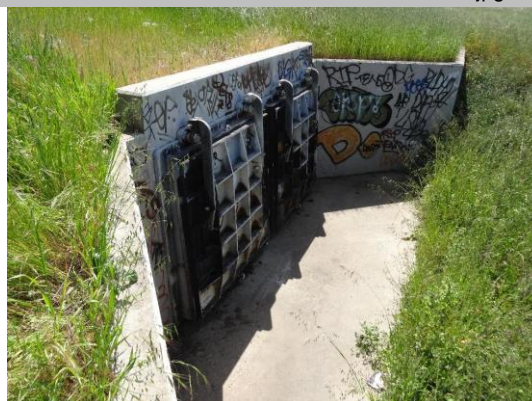
Photo 1 of 3 : UCIP\_FA\_2018\_35463\_63782.jpg

WS view: outlet structure with two flapgates and concrete spillway on levee toe.

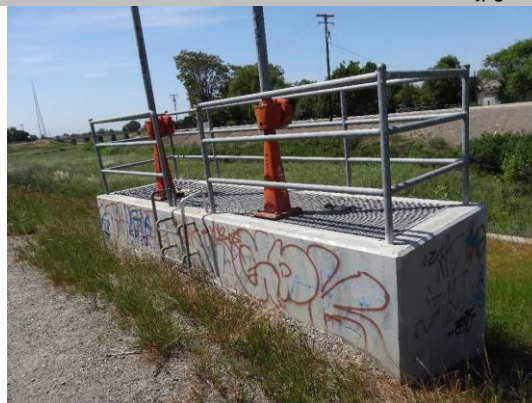
Photo 2 of 3 : UCIP\_FA\_2018\_35463\_63781.jpg

WS view: two slide gates in concrete box on levee shoulder.

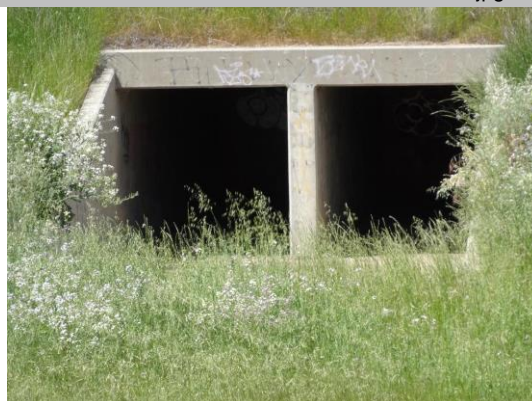
Photo 3 of 3 : UCIP\_FA\_2018\_35463\_63780.jpg

LS view: double 6 ft by 6 ft concrete box culvert through the levee.

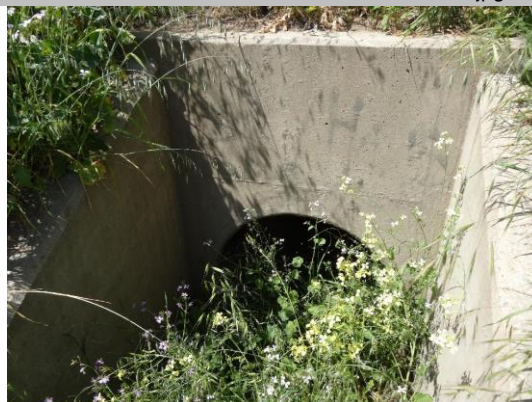
Photo 1 of 3 : UCIP\_FA\_2018\_35203\_63345.jpg

LS view: U type concrete headwall and CM pipe on levee slope.

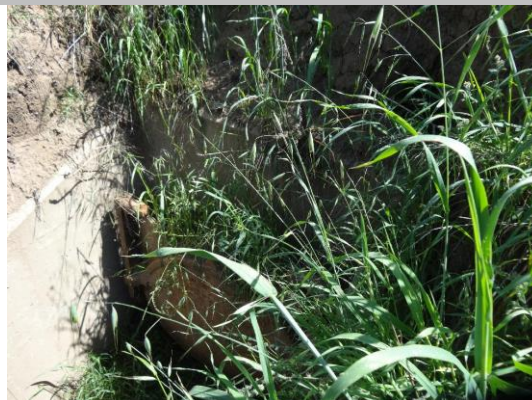
Photo 3 of 3 : UCIP\_FA\_2018\_35203\_63343.jpg

WS view: U type concrete headwall, CM pipe with flapgate, and concrete spillway on levee slope.

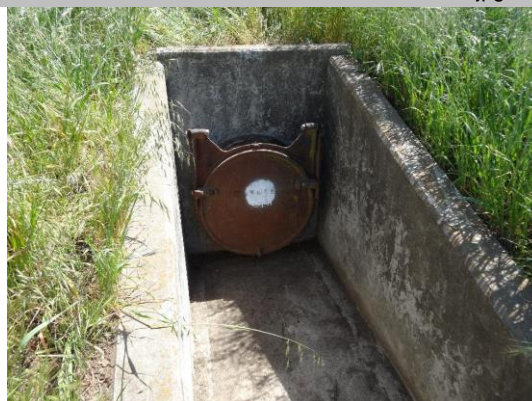
Photo 1 of 2 : UCIP\_FA\_2018\_35204\_63349.jpg

WS view: U type concrete headwall, CM pipe with flapgate, and concrete spillway on levee slope.

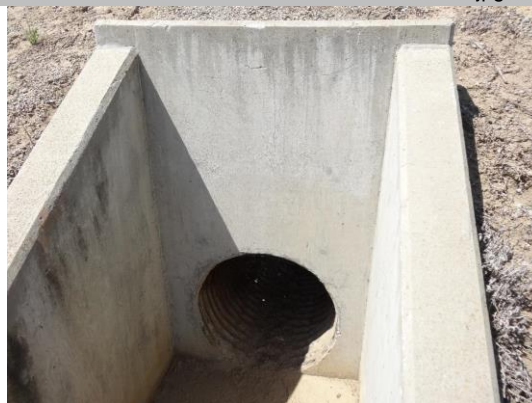
Photo 2 of 2 : UCIP\_FA\_2018\_35204\_63348.jpg

LS view: U type concrete headwall and CM pipe on levee slope.

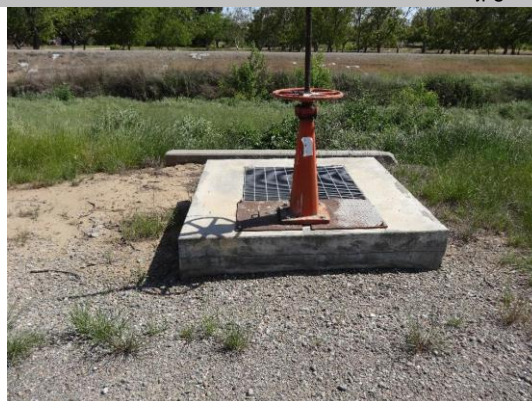
Photo 1 of 3 : UCIP\_FA\_2018\_35206\_63361.jpg

WS view: slide gate in a concrete box on levee shoulder.

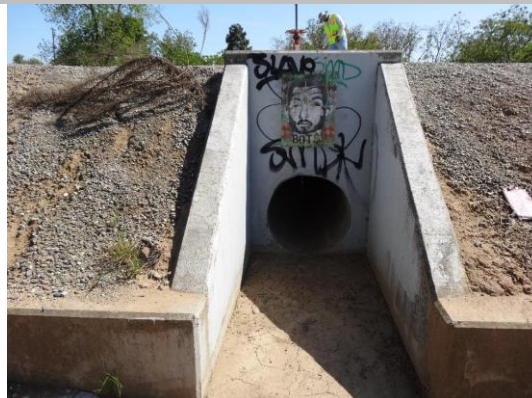
Photo 3 of 3 : UCIP\_FA\_2018\_35206\_63359.jpg

LS view: U type concrete headwall and CM pipe on levee slope.

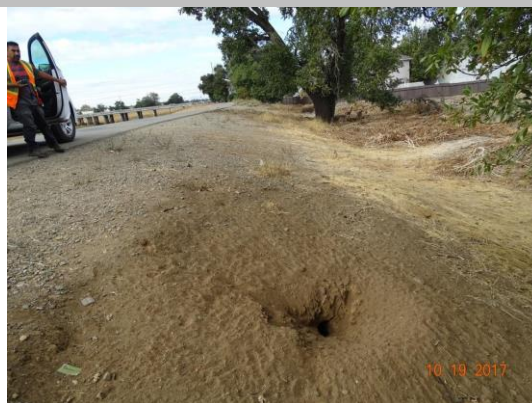
Photo 1 of 1 : FA\_2018\_NA0017\_159\_171\_20181001\_00104.jpg

LM Start	19.92	Rating **	M	Issue No.	171
LM End	19.92	Issue Type +	Ma	Location *	LS
Category	Earthen Levee			GPS Latitude/Longitude	
				Start	End
Item	Animal Control			37.993707 °	37.993707 °
				-121.284852 °	-121.284852 °
DWR ID	DWR_NA0017_15_f_2017_171				
Comment Code					
A3 : No rodents visible, but rodent burrows visible; need to backfill and compact or grout burrows.					
Inspector Comment

View of a rodent hole on the landside of the levee. Fall 2017

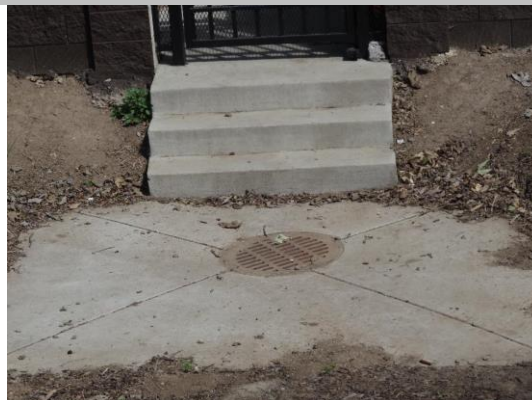
Photo 2 of 2 : UCIP\_FA\_2018\_35263\_63420.jpg

LS view: a manhole on levee toe.

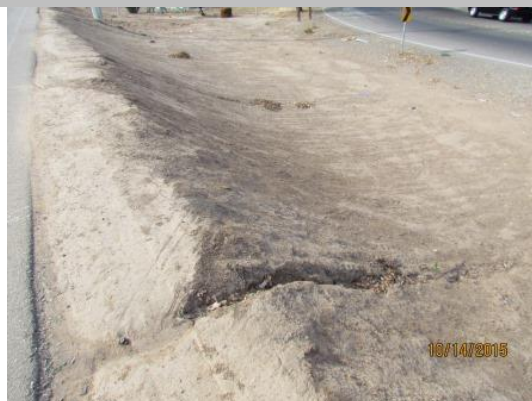
Photo 1 of 1 : FA\_2018\_NA0017\_159\_172\_20181001\_00105.jpg

LM Start	21.25	Rating **	M	Issue No.	172
LM End	21.25	Issue Type +	Ma	Location *	LS
Category	Earthen Levee			GPS Latitude/Longitude	
				Start	End
Item	Erosion / Bank Caving			37.988969 °	37.988969 °
				-121.307009 °	-121.307009 °
DWR ID	DWR_NA0017_15_f_2015_172				
Comment Code					
E2 : Schedule repair of erosion site prior to the next inspection.					
Inspector Comment					
Runoff.

Erosion was found on the landside of the levee looking downstream.

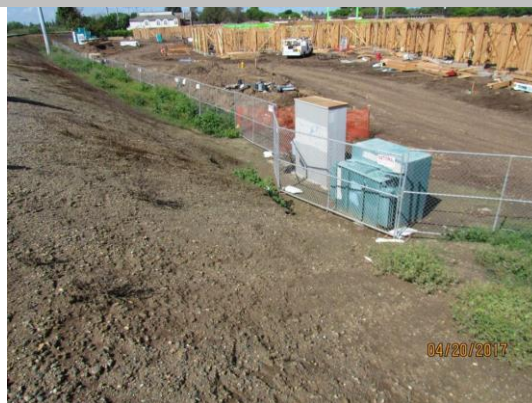
Photo 1 of 1 : FA\_2018\_NA0017\_159\_240\_20181001\_00133.jpg

LM Start	21.95	Rating **	M	Issue No.	240
LM End	21.95	Issue Type +	Ma	Location *	LS
Category	Earthen Levee			GPS Latitude/Longitude	
				Start	End
Item	Erosion / Bank Caving			37.981308 °	37.981308 °
				-121.314831 °	-121.314831 °
DWR ID	DWR_NA0017_15_s_2017_240				
Comment Code					
E1 : Note and monitor erosion site.					
Inspector Comment					
Landside toe erosion.

View of erosion on the landside toe of the levee.

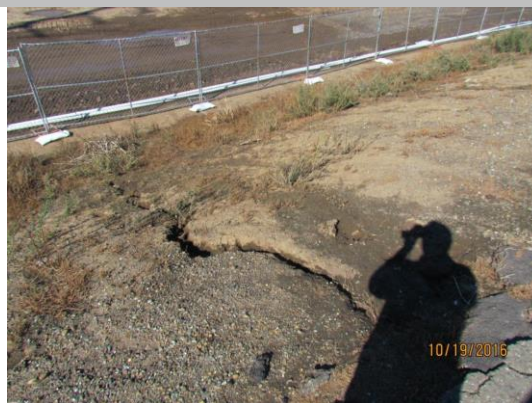
Photo 1 of 2 : FA\_2018\_NA0017\_159\_173\_20181001\_00106.jpg

LM Start	21.96	Rating **	M	Issue No.	173
LM End	21.96	Issue Type +	Ma	Location *	LS
Category	Earthen Levee			GPS Latitude/Longitude	
				Start	End
Item	Erosion / Bank Caving			37.981147 °	37.981147 °
				-121.315071 °	-121.315071 °
DWR ID	DWR_NA0017_15_s_2012_173				
Comment Code					
E2 : Schedule repair of erosion site prior to the next inspection.					
Inspector Comment					
Runoff.

Updated picture of erosion due to runoff on the landside slope of the levee during fall 2016 inspection.

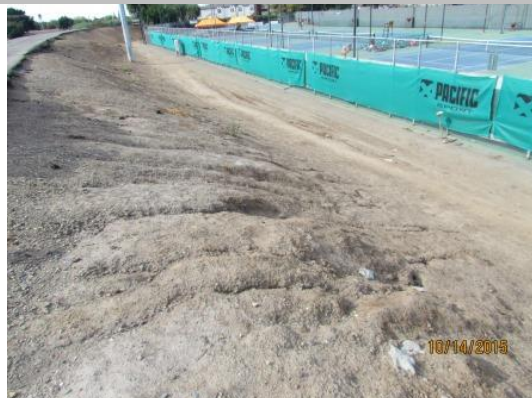
Photo 2 of 2 : FA\_2018\_NA0017\_159\_173\_20181001\_00107.jpg

LM Start	21.96	Rating **	M	Issue No.	173 (cont)	
LM End	21.96	Issue Type +	Ma	Location *	LS	
Category	Earthen Levee			GPS Latitude/Longitude		
				Start		End
Item	Erosion / Bank Caving			37.981147 °		37.981147 °
				-121.315071 °		-121.315071 °
DWR ID	DWR_NA0017_15_s_2012_173					
Comment Code						
E2 : Schedule repair of erosion site prior to the next inspection.						
Inspector Comment						
Runoff.

View of the erosion caused by run off on the landside slope of the levee looking downstream during fall 2015 inspection.

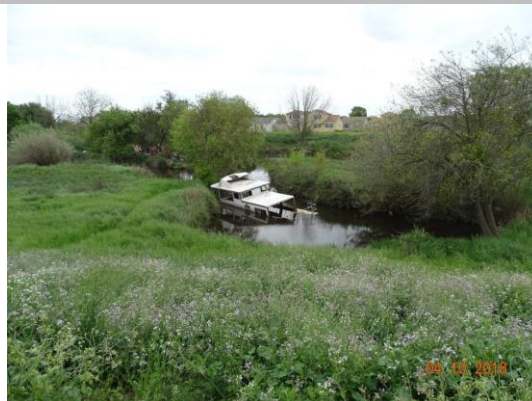
Photo 1 of 1 : FA\_2018\_NA0017\_159\_221\_20181001\_00127.jpg

LM Start	22.37	Rating **	M	Issue No.	221
LM End	22.37	Issue Type +	Ma	Location *	WS
Category	Rivers, Channels & Designated Floodways			GPS Latitude/Longitude	
				Start	End
Item	Encroachments			37.981438 °	37.981438 °
				-121.321718 °	-121.321718 °
DWR ID	DWR_NA0017_15_s_2018_221				
Comment Code					
Inspector Comment					
An abandoned partially submerged boat is located in the channel.

Encroachment abandoned boat in channel looking south.

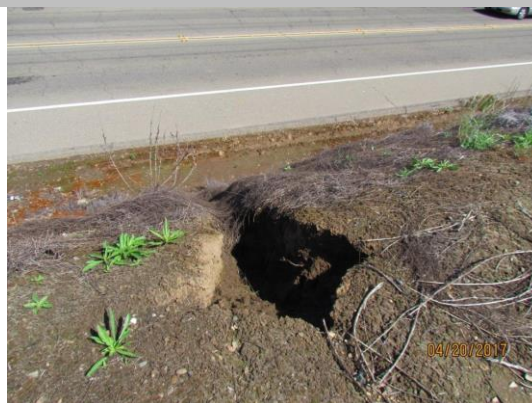
Photo 1 of 1 : FA\_2018\_NA0017\_159\_185\_20181001\_00111.jpg

LM Start	22.88	Rating **	M	Issue No.	185
LM End	22.88	Issue Type +	Ma	Location *	LS
Category	Earthen Levee			GPS Latitude/Longitude	
				Start	End
Item	Erosion / Bank Caving			37.981278 °	37.981278 °
				-121.330566 °	-121.330566 °
DWR ID	DWR_NA0017_15_f_2016_185				
Comment Code					
E2 : Schedule repair of erosion site prior to the next inspection.					
Inspector Comment					
Runoff

View of an erosion due to runoff on the landside of the levee. Spring 2017

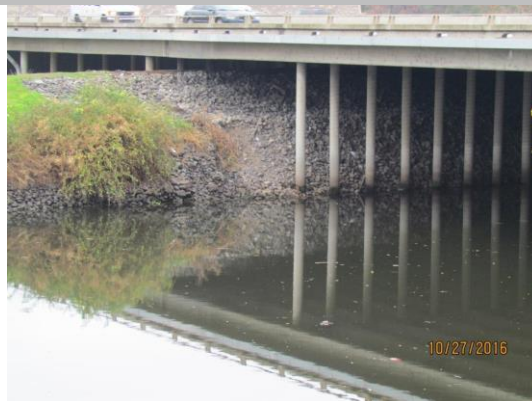
Photo 1 of 1 : FA\_2018\_NA0017\_159\_223\_20181001\_00128.jpg

LM Start	23.55	Rating **	A/W	Issue No.	223
LM End	23.55	Issue Type +	Ma	Location *	WS
Category	Earthen Levee			GPS Latitude/Longitude	
				Start	End
Item	Riprap Revetments			37.979282 °	37.979282 °
				-121.341686 °	-121.341686 °
DWR ID	DWR_NA0017_15_f_2016_223				
Comment Code					
Inspector Comment					
Wrong revetment size was placed by Caltrans in Fall 2012 under permit #18562. An NOV was issued to Caltrans. They repaired the left bank, but have not repaired the right bank of the levee. Caltrans will be responsible for any repairs at this location.

View of deteriorating revetments on the waterside toe of the levee. The picture was taken from the opposite side of the levee. Fall 2016

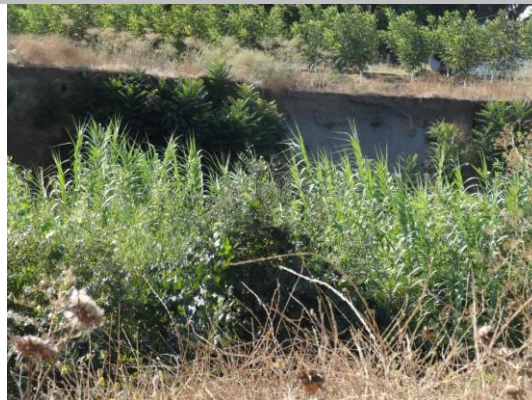
Photo 1 of 4 : FA\_2018\_NA0017\_160\_86\_20181003\_00132.jpg

Comment Code					
Inspector Comment					
08/30/2017: The erosion has cut further into the river bank. Newly collapsed material is observed at the bottom of the erosion site.					
08/16/2016: The erosion site was found progressed with signs of bank slipping.					
08/12/2015: The erosion progressed at the site. Newly collapsed material is observed at the bottom of the erosion.					
08/20/2014: The erosion at the site has worsened. The erosion increased in both length and in height.					
09/12/2013: Site has been visited and signs of new erosion are visible.					
08/22/2012: The erosion was surveyed and documented for monitoring purpose. There is no levee structure on the site, only high ground protecting the land behind. The levee crest width and levee height were not measured or estimated in the field. [2017 Site ID:NA0017U16RM23.35]

Front view of the erosion looking from the right bank side of the river.

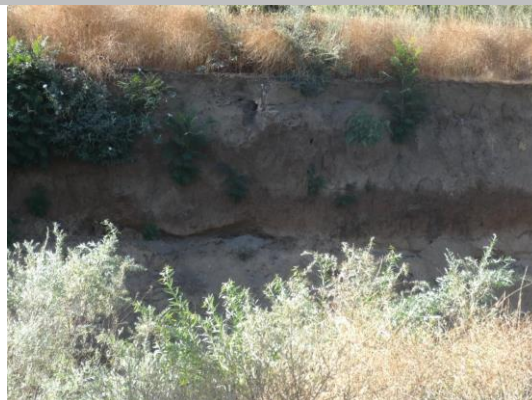
Photo 2 of 4 : FA\_2018\_NA0017\_160\_86\_20181003\_00133.jpg

Close view of the erosion. Signs of new erosion along the site.

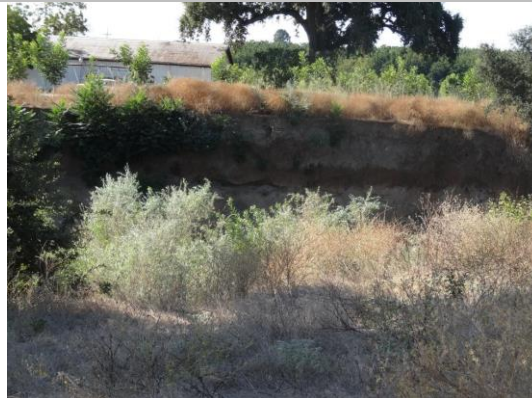
Photo 3 of 4 : FA\_2018\_NA0017\_160\_86\_20181003\_00134.jpg

Close view of the erosion.

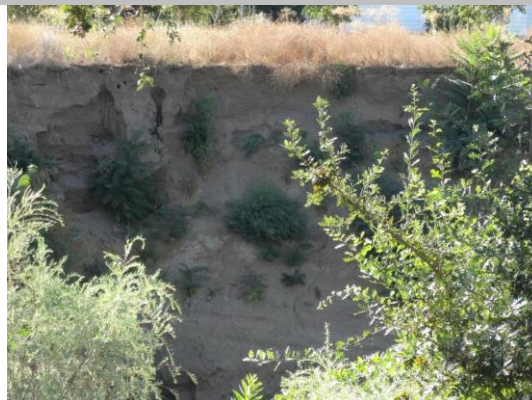
Photo 4 of 4 : FA\_2018\_NA0017\_160\_86\_20181003\_00135.jpg

Close view of the erosion.

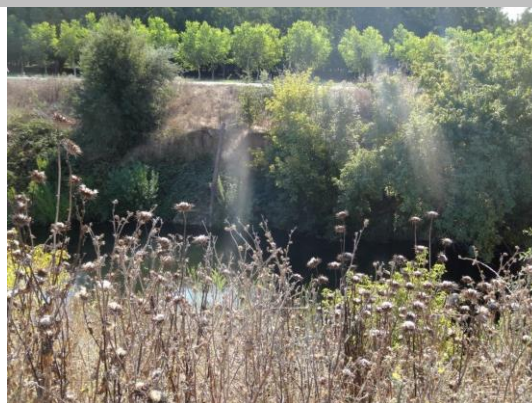
Photo 1 of 4 : FA\_2018\_NA0017\_160\_83\_20181003\_00127.jpg

Comment Code					
Inspector Comment					
08/30/2017: No significant change observed.					
08/16/2016: No significant change observed.					
08/12/2015: No significant change observed.					
08/20/2014: No significant change observed.					
09/12/2013: No significant change observed.					
08/22/2012: The erosion was surveyed and documented for monitoring purpose. There is no levee structure on the site, only high ground protecting the land behind. The levee crest width and levee height were not measured or estimated in the field.					
There is a drainage pipe at the site, which might have caused the problem at one pocket erosion. [2017 Site ID:NA0017U16RM22.74]

View of the site from right river bank.

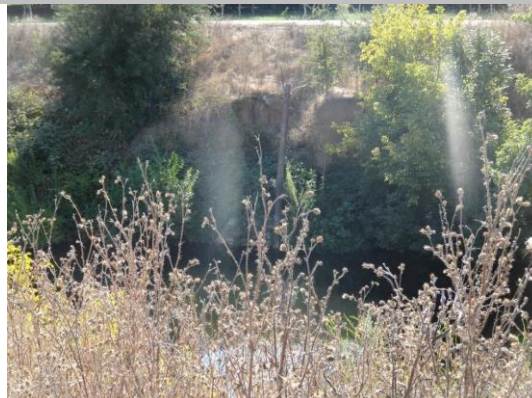
Photo 4 of 4 : FA\_2018\_NA0017\_160\_83\_20181003\_00130.jpg

Close view of the site.

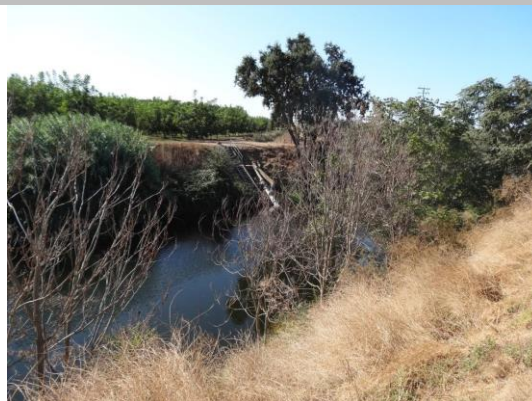
Photo 1 of 3 : FA\_2018\_NA0017\_160\_82\_20181003\_00124.jpg

LM Start	1.12	Rating **	U	Issue No.	82
LM End	1.12	Issue Type +	Ma	Location *	WS
Category	Supplemental			GPS Latitude/Longitude	
				Start	End
Item	DWR Erosion Survey			38.040757 °	38.040757 °
				-121.027786 °	-121.027786 °
DWR ID	NA0017U16RM22.58				
Comment Code					
Inspector Comment					
08/30/2017: No significant change observed. 08/16/2016: No significant change observed. 08/12/2015: No significant change observed. 08/20/2014: No significant change observed. 09/12/2013: No significant change observed. 08/22/2012: The erosion is at the outside corner of a river bend, and next to a tree at the levee toe. Irrigation structure presents at the site. There is no levee structure on site. The levee crest width and levee height were not measured or estimated in the field. [2017 Site ID:NA0017U16RM22.58]

Front view of the erosion. The erosion is next to a tree at the levee toe.

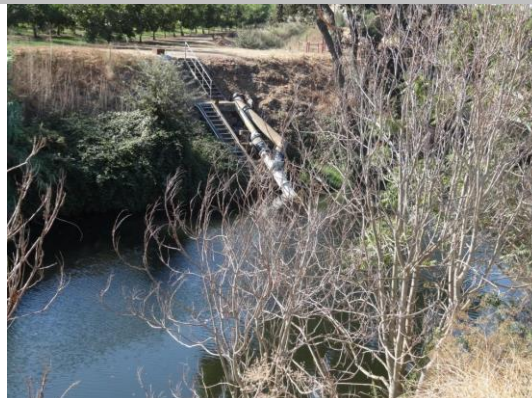
Photo 2 of 3 : FA\_2018\_NA0017\_160\_82\_20181003\_00125.jpg

Close view of the erosion.

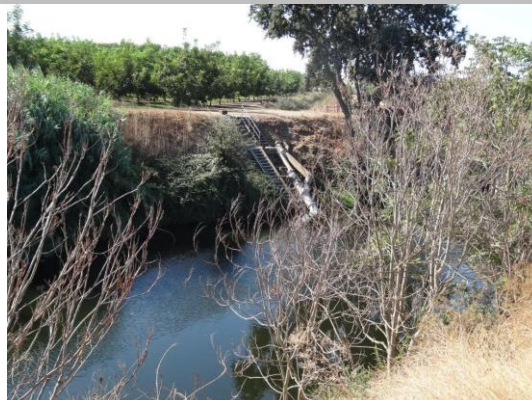
Photo 3 of 3 : FA\_2018\_NA0017\_160\_82\_20181003\_00126.jpg

Front view of the erosion.

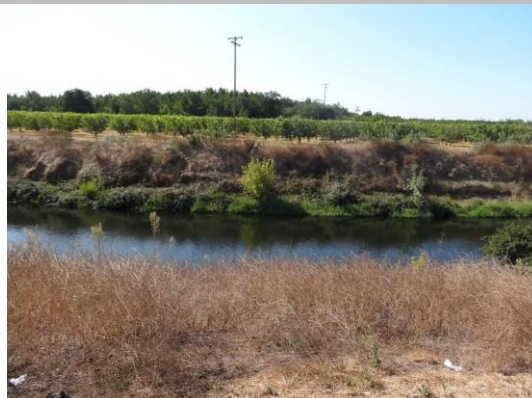
Photo 1 of 4 : FA\_2018\_NA0017\_160\_80\_20181003\_00120.jpg

LM Start	1.67	Rating **	M	Issue No.	80
LM End	1.67	Issue Type +	Ma	Location *	WS
Category	Supplemental			GPS Latitude/Longitude	
				Start	End
Item	DWR Erosion Survey			38.038751 °	38.038751 °
				-121.037347 °	-121.037347 °
DWR ID	NA0017U16RM22.15				
Comment Code					
Inspector Comment					
08/30/2017: No significant change observed.					
08/16/2016: No significant change observed.					
08/12/2015: No significant change observed.					
08/20/2014: No significant change observed.					
09/12/2013: No significant change observed.					
08/22/2012: The berm is estimated at 10 ft. Dense vegetation on site.					
There is no levee structure on site. The levee crest width and levee height were not measured or estimated in the field. [2017 Site ID:NA0017U16RM22.15]

Front view of the erosion.

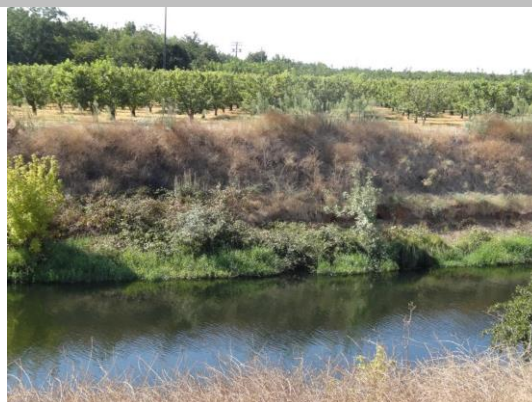
Photo 2 of 4 : FA\_2018\_NA0017\_160\_80\_20181003\_00121.jpg

Close view of the erosion.

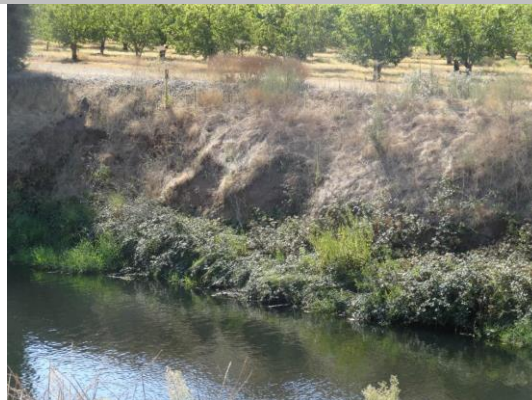
Photo 3 of 4 : FA\_2018\_NA0017\_160\_80\_20181003\_00122.jpg

Close view of the erosion.

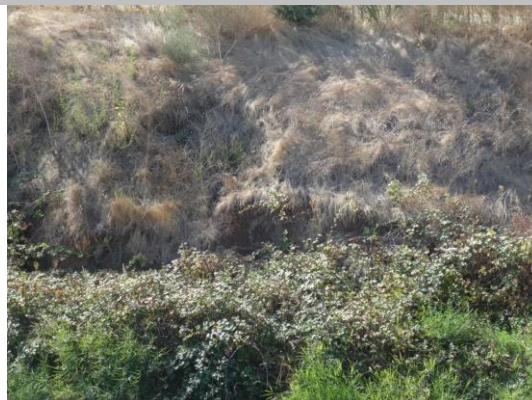
Photo 4 of 4 : FA\_2018\_NA0017\_160\_80\_20181003\_00123.jpg

Close view of the erosion. Note the dense vegetation at the site.
