**Flood Control Project Maintenance  
Levee Inspections**

**Maintenance Issue Types Only, Levee Inspection Report By Mile - Fall 2018**

**San Joaquin County Flood Control and Water Conservation District**

Waterway	Bank	Unit Miles	Inspection Start/End	Inspector
Unit No. 01 Littlejohn Creek	Left	2.59	10/18/2018 10/18/2018	Wade Wylie

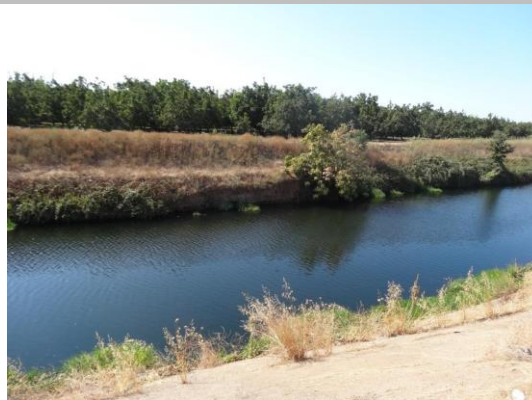
Photo 1 of 4 : FA\_2018\_NA0017\_160\_76\_20181003\_00114.jpg

08/30/2017: No significant change observed.  
 08/16/2016: No significant change observed.  
 08/12/2015: No significant change observed.  
 08/20/2014: No significant change observed.  
 09/12/2013: No significant change observed.  
 08/22/2012: The erosion is covered by dense vegetation. There is no levee structure on site. The levee crest width and levee height were not measured or estimated in the field. [2017 Site ID:NA0017U16RM21.95]

Front view of the erosion site.

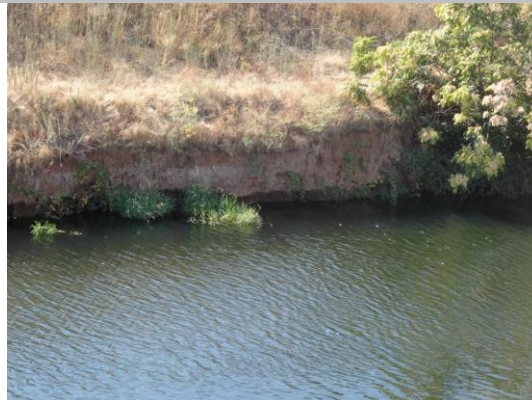
Photo 2 of 4 : FA\_2018\_NA0017\_160\_76\_20181003\_00115.jpg

Close view of the erosion.

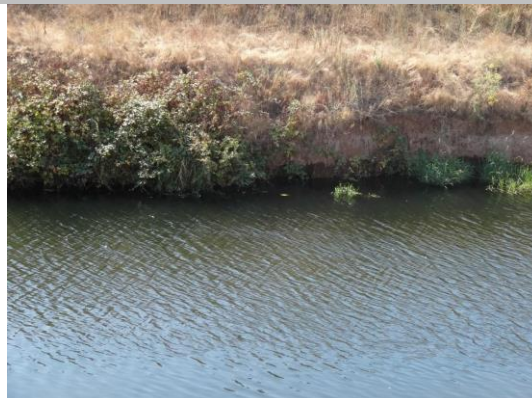
Photo 3 of 4 : FA\_2018\_NA0017\_160\_76\_20181003\_00116.jpg

Close view of the erosion.

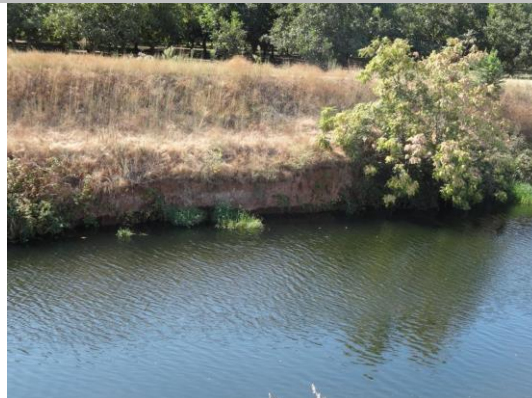
Photo 4 of 4 : FA\_2018\_NA0017\_160\_76\_20181003\_00117.jpg

Close view of the erosion.

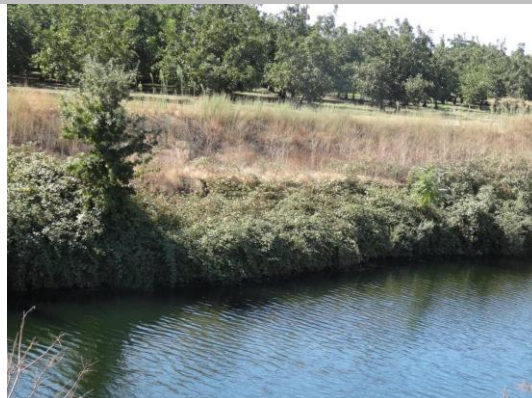
Photo 1 of 4 : FA\_2018\_NA0017\_160\_75\_20181003\_00110.jpg

08/30/2017: No significant change observed. The site is covered by dense vegetation.  
 08/16/2016: No significant change observed.  
 08/12/2015: No significant change observed.  
 08/20/2014: No significant change observed.  
 09/12/2013: No significant change observed.  
 08/22/2012: Site is covered by dense vegetation. Berm width is estimated as 5 ft. There is no levee structure on site. The levee crest width and levee height were not measured or estimated in the field.  
 [2017 Site ID:NA0017U16RM21.94]

Looking at the erosion from right river bank.

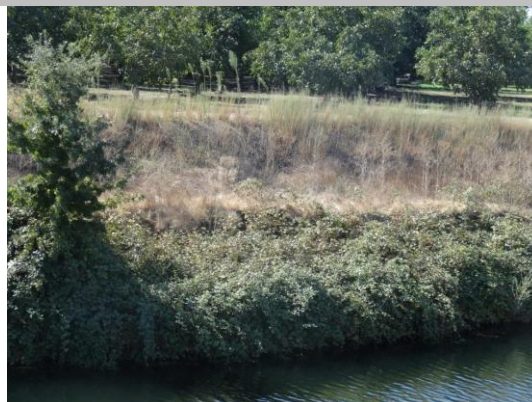
Photo 2 of 4 : FA\_2018\_NA0017\_160\_75\_20181003\_00111.jpg

Front view of the erosion.

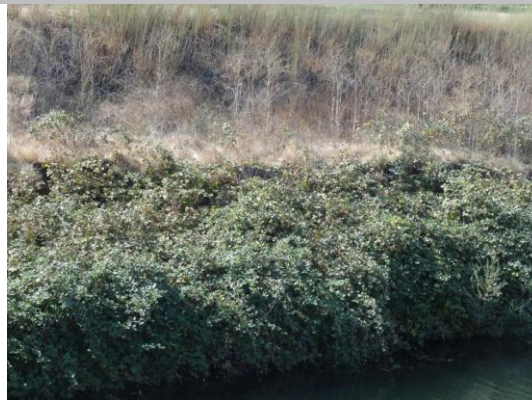
Photo 3 of 4 : FA\_2018\_NA0017\_160\_75\_20181003\_00112.jpg

Close view of the erosion.

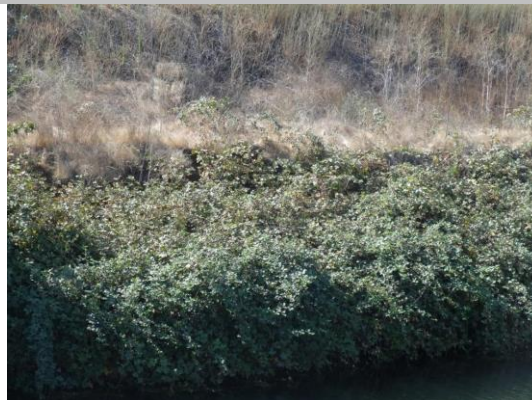
Photo 4 of 4 : FA\_2018\_NA0017\_160\_75\_20181003\_00113.jpg

Close view of the erosion. Note the dense vegetation at the site.

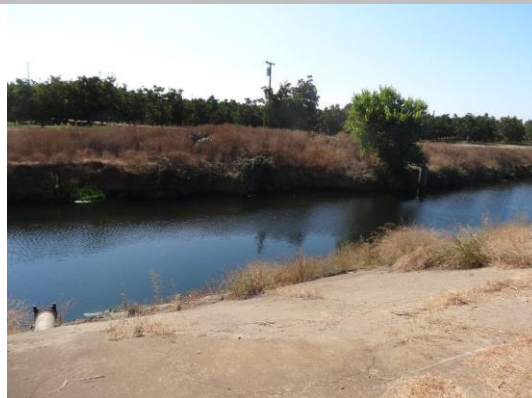
Photo 1 of 4 : FA\_2018\_NA0017\_160\_74\_20181003\_00106.jpg

LM Start	1.88	Rating **	M	Issue No.	74
LM End	1.90	Issue Type +	Ma	Location *	WS
Category	Supplemental			GPS Latitude/Longitude	
				Start	End
Item	DWR Erosion Survey			38.036549 °	38.036549 °
				-121.040302 °	-121.040302 °
DWR ID	NA0017U16RM21.05				
Comment Code					
Inspector Comment					
08/30/2017: No significant change observed.					
08/16/2016: No significant change observed.					
08/12/2015: No significant change observed.					
08/20/2014: No significant change observed.					
09/12/2013: No significant change observed.					
08/22/2012: Berm width is estimated as 5 ft. There is no levee structure on site. The levee crest width and levee height were not measured or estimated in the field. [2017 Site ID:NA0017U16RM21.05]

Front view of the erosion

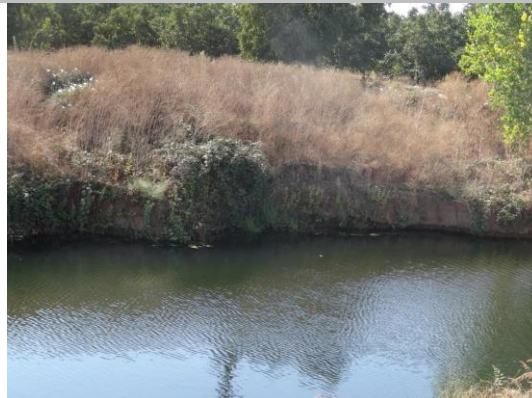
Photo 2 of 4 : FA\_2018\_NA0017\_160\_74\_20181003\_00107.jpg

Close view of the erosion.

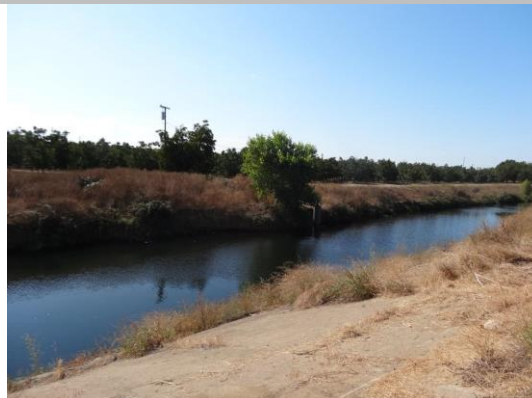
Photo 3 of 4 : FA\_2018\_NA0017\_160\_74\_20181003\_00108.jpg

Front view of the erosion.

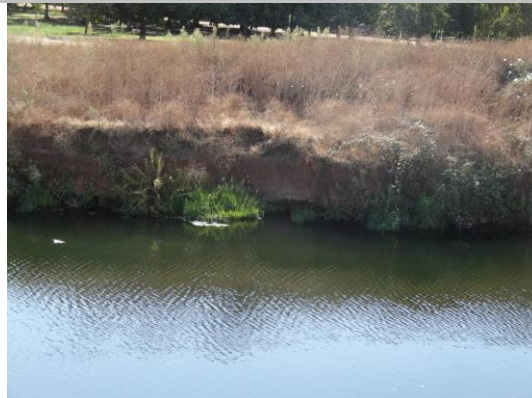
Photo 4 of 4 : FA\_2018\_NA0017\_160\_74\_20181003\_00109.jpg

Close view of the erosion.

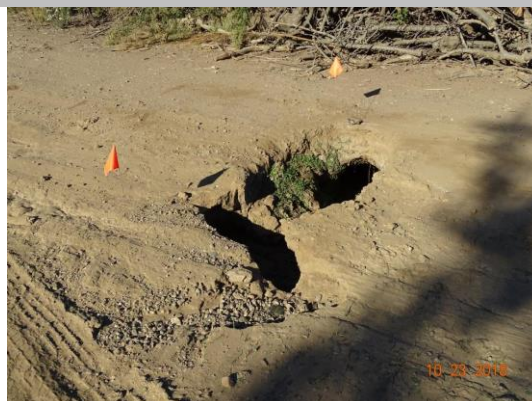
Photo 1 of 1 : FA\_2018\_NA0017\_160\_236\_20181024\_00452.jpg

LM Start	2.01	Rating **	U	Issue No.	236
LM End	2.01	Issue Type +	Ma	Location *	CR
Category	Earthen Levee			GPS Latitude/Longitude	
				Start	End
Item	Animal Control			38.035050 °	38.035050 °
				-121.041225 °	-121.041225 °
DWR ID	DWR_NA0017_16_f_2018_236				
Comment Code					
A1 : Exterminate rodents and backfill and compact or grout burrows.					
Inspector Comment					
Large hole in the road due to animal activity

View of large holes in the crown of the levee (October 2018).

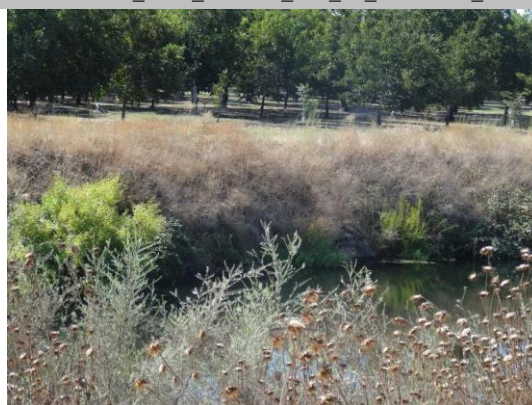
Photo 1 of 4 : FA\_2018\_NA0017\_160\_66\_20181003\_00092.jpg

LM Start	2.30	Rating **	U	Issue No.	66
LM End	2.31	Issue Type +	Ma	Location *	WS
Category	Supplemental			GPS Latitude/Longitude	
				Start	End
Item	DWR Erosion Survey			38.032202 °	38.032202 °
				-121.045226 °	-121.045226 °
DWR ID	NA0017U16RM20.62				
Comment Code					
Inspector Comment					
08/30/2017: No significant change observed.					
08/16/2016: No significant change observed.					
08/12/2015: No significant change observed.					
08/20/2014: No significant change has been observed.					
09/12/2013: No significant change observed.					
08/22/2012: The erosion was first reported in the 2012 spring levee inspection report. There is no levee structure on site. The levee crest width and levee height were not measured or estimated in the field.					
[2017 Site ID:NA0017U16RM20.62]

Front view of the site.

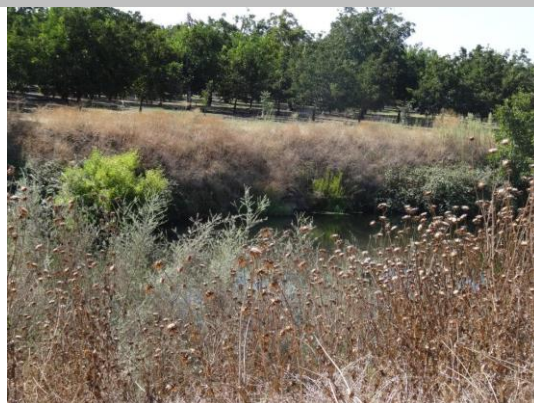
Photo 2 of 4 : FA\_2018\_NA0017\_160\_66\_20181003\_00093.jpg

Close view of the erosion. Note the vegetation at the site.

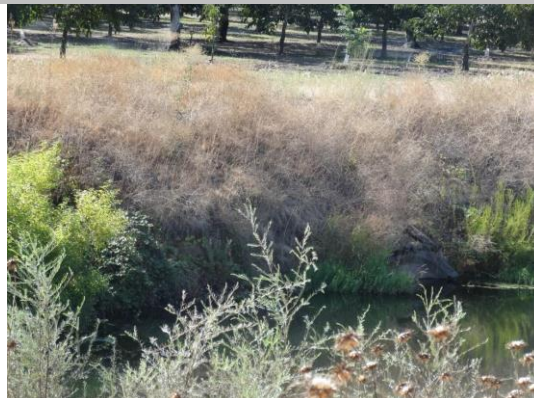
Photo 4 of 4 : FA\_2018\_NA0017\_160\_66\_20181003\_00095.jpg

Close view of the site.

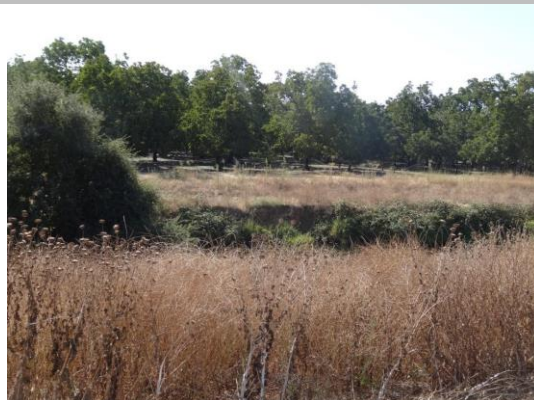
Photo 1 of 4 : FA\_2018\_NA0017\_160\_70\_20181003\_00099.jpg

LM Start	2.30	Rating **	M	Issue No.	70
LM End	2.31	Issue Type +	Ma	Location *	WS
Category	Supplemental			GPS Latitude/Longitude	
				Start	End
Item	DWR Erosion Survey			38.033072 °	38.033072 °
				-121.044970 °	-121.044970 °
DWR ID	NA0017U16RM20.71				
Comment Code					
Inspector Comment					
08/30/2017: No significant change observed.					
08/16/2016: No significant change observed.					
08/12/2015: No significant change observed.					
08/20/2014: No significant change observed.					
09/12/2013: No significant change observed.					
08/22/2012: Site is covered with dense vegetation. There is no levee structure on site. The levee crest width and levee height were not measured or estimated in the field. [2017 Site ID:NA0017U16RM20.71]

Front view of the site from the levee top on the other side of the river.

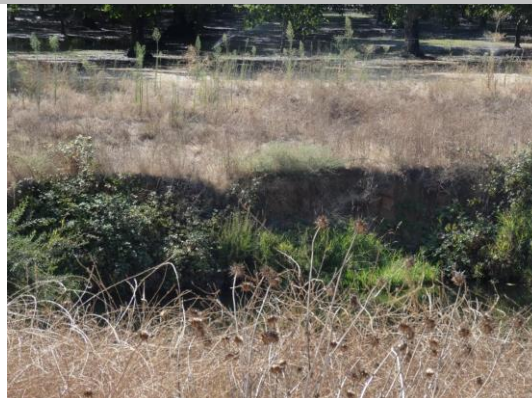
Photo 2 of 4 : FA\_2018\_NA0017\_160\_70\_20181003\_00100.jpg

LM Start	2.30	Rating **	M	Issue No.	70 (cont)	
LM End	2.31	Issue Type +	Ma	Location *	WS	
Category	Supplemental			GPS Latitude/Longitude		
				Start	End	
Item	DWR Erosion Survey			38.033072 °	38.033072 °	
				-121.044970 °	-121.044970 °	
DWR ID	NA0017U16RM20.71					
Comment Code						
Inspector Comment						
08/30/2017: No significant change observed.						
08/16/2016: No significant change observed.						
08/12/2015: No significant change observed.						
08/20/2014: No significant change observed.						
09/12/2013: No significant change observed.						
08/22/2012: Site is covered with dense vegetation. There is no levee structure on site. The levee crest width and levee height were not measured or estimated in the field. [2017 Site ID:NA0017U16RM20.71]

Close view of the erosion. Site is covered with vegetation and trees.

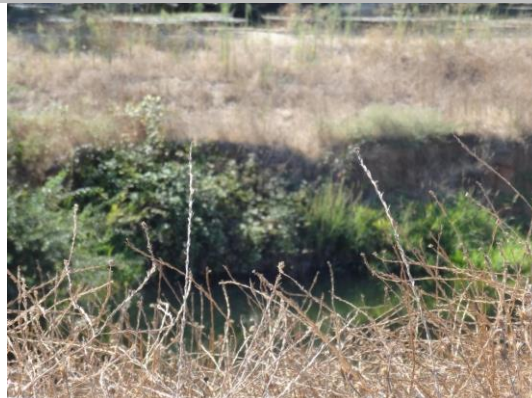
Photo 3 of 4 : FA\_2018\_NA0017\_160\_70\_20181003\_00101.jpg

Close view of the erosion.

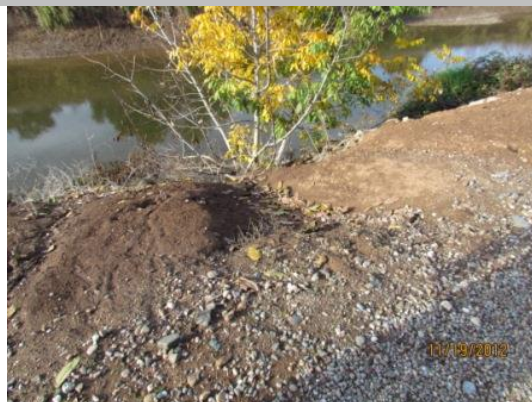
Photo 1 of 2 : FA\_2018\_NA0017\_160\_213\_20181003\_00176.jpg

Updated picture of the slope instability on the waterside shoulder of the levee looking upstream.

LM Start	2.35	Rating **	A/W	Issue No.	213
LM End	2.35	Issue Type +	Ma	Location *	WS
Category	Earthen Levee			GPS Latitude/Longitude	
				Start	End
Item	Slope Stability			38.031763 °	38.031763 °
				-121.045808 °	-121.045808 °
DWR ID	DWR_NA0017_16_f_2012_213				
Comment Code					
S1 : Repair slope instability.					
Inspector Comment

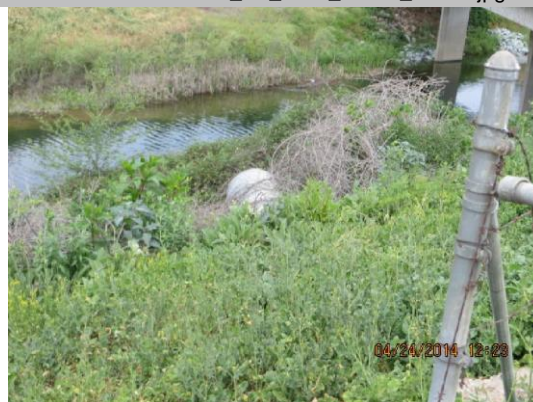
Photo 2 of 3 : UCIP\_FA\_2018\_53506\_64066.jpg

Pipe outlet on WS slope.

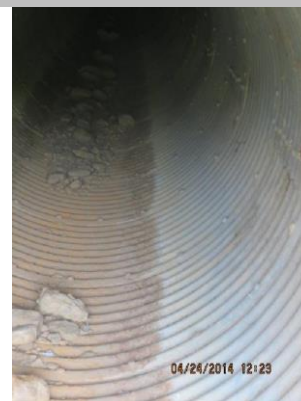
Photo 3 of 3 : UCIP\_FA\_2018\_53506\_64065.jpg

Comment Code						
Inspector Comment						
FS_ID:53506						
DS_ID:23446						
EP_NO: N/A						
Repair Type: Non-Urgent						
Crossing Status: Found						
UCIP Comments: 09/18/2018 Lots of sediment in the inlet: needs to be cleared out. No integrity issues, yet there's dense vegetation and potential flooding risk during high water. Crossing downgraded to "Non-Urgent." (A. McDonald - DWR UCIP)10/31/2016 Same as last inspection. Pipe is open on both ends, no flap gate. (O. Magana - DWR UCIP)04/24/2014 Pipe in non-project levee area. Pipe open on both ends, no flapgate. (W. Wylie - DWR UCIP)						
FIELD_STRUCT_DESC: 36-inch corrugated metal drainage culvert through the levee, 10 feet below the crown. Pipe open on both ends.						
[Additional Reference(s): USACE San Joaquin O&M Manual Unit 611, Part No. 1 – Mormon Slough Project, Unit 15 Mormon Slough: HLM 1.18 – 13.46, Unit 15 Diverting Canal: HLM 13.79 – 18.01, Unit 15 Calaveras River LB: 18.54-18.76, Unit 15 Calaveras River RB: HLM 19.35 – 25.38, Unit 16 Mormon Slough: 0.27 – 13.18, Unit 16 Diverting Canal: 14.71 – 17.79, Unit 16 Calaveras River: 18.98 – 23.36, Unit 17 Potter Creek RB: 0.33 – 0.60, Unit 18 Potter Creek LB: 0.00-0.55, (HLM 2.82)]

inside pipe on LS toe.

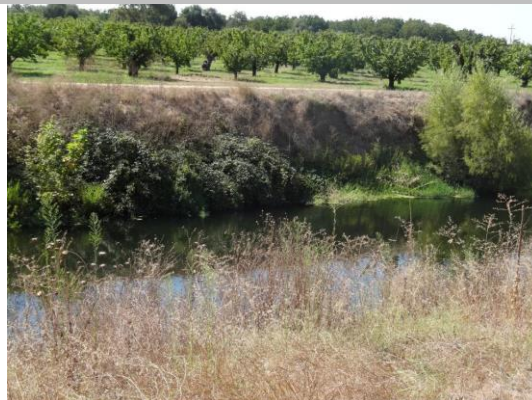
Photo 1 of 4 : FA\_2018\_NA0017\_160\_64\_20181003\_00087.jpg

LM Start	2.85	Rating **	U	Issue No.	64
LM End	2.91	Issue Type +	Ma	Location *	WS
Category	Supplemental			GPS Latitude/Longitude	
				Start	End
Item	DWR Erosion Survey			38.026670 °	38.026670 °
				-121.053031 °	-121.053031 °
DWR ID	NA0017U16RM20				
Comment Code					
Inspector Comment					
08/30/2017: No significant change observed.					
08/16/2016: No significant change observed.					
08/12/2015: No significant change observed.					
08/20/2014: No significant change observed.					
09/12/2013: No significant change observed.					
08/22/2012: Site Comprised of series of pocket and scarp erosions.					
Some of erosions are covered by grass or shrubs. There is no levee					
structure on site. The levee crest width and levee height were not					
measured or estimated in the field. [2017 Site ID:NA0017U16RM20]

Front view of the erosion.

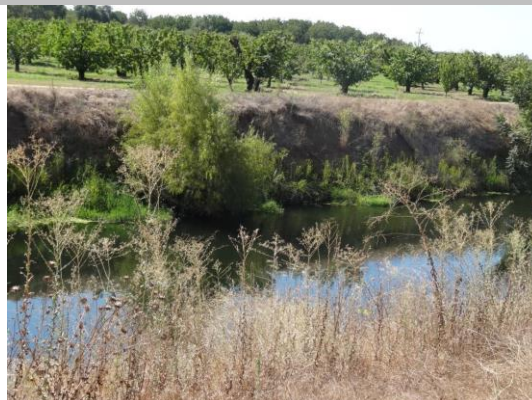
Photo 2 of 4 : FA\_2018\_NA0017\_160\_64\_20181003\_00088.jpg

Close view of the erosion.

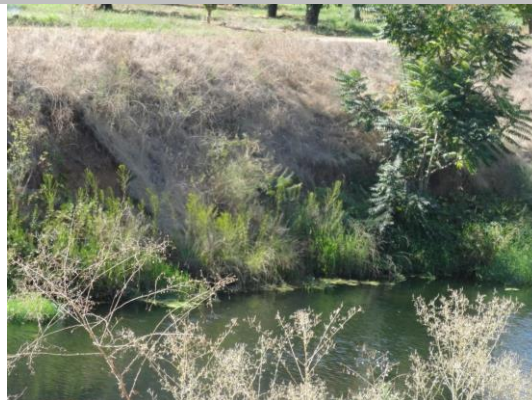
Photo 3 of 4 : FA\_2018\_NA0017\_160\_64\_20181003\_00089.jpg

LM Start	2.85	Rating **	U	Issue No.	64 (cont)	
LM End	2.91	Issue Type +	Ma	Location *	WS	
Category	Supplemental			GPS Latitude/Longitude		
				Start	End	
Item	DWR Erosion Survey			38.026670 °	38.026670 °	
				-121.053031 °	-121.053031 °	
DWR ID	NA0017U16RM20					
Comment Code						
Inspector Comment						
08/30/2017: No significant change observed.						
08/16/2016: No significant change observed.						
08/12/2015: No significant change observed.						
08/20/2014: No significant change observed.						
09/12/2013: No significant change observed.						
08/22/2012: Site Comprised of series of pocket and scarp erosions.						
Some of erosions are covered by grass or shrubs. There is no levee						
structure on site. The levee crest width and levee height were not						
measured or estimated in the field. [2017 Site ID:NA0017U16RM20]

Close view of the erosion.

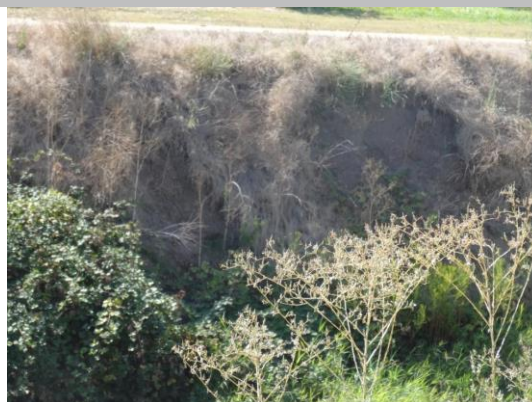
Photo 4 of 4 : FA\_2018\_NA0017\_160\_64\_20181003\_00090.jpg

Close view of the scarp erosion. Note the small tree at the erosion site.

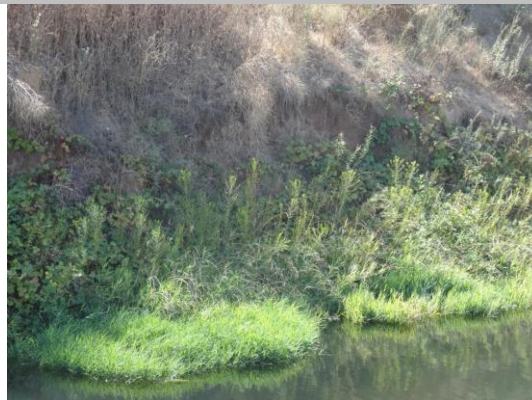
Photo 3 of 4 : FA\_2018\_NA0017\_160\_54\_20181003\_00078.jpg

LM Start	3.61	Rating **	M	Issue No.	54 (cont)	
LM End	3.61	Issue Type +	Ma	Location *	WS	
Category	Supplemental			GPS Latitude/Longitude		
				Start		End
Item	DWR Erosion Survey			38.019642 °		38.019642 °
				-121.062917 °		-121.062917 °
DWR ID	NA0017U16RM19.29					
Comment Code						
Inspector Comment						
08/30/2017: No significant change observed.						
08/16/2016: No significant change observed.						
08/12/2015: No significant change observed.						
08/20/2014: A pocket erosion was found near the water's edge. [2017						
Site ID:NA0017U16RM19.29]

Close view of the erosion. Note the dense vegetation at the site.

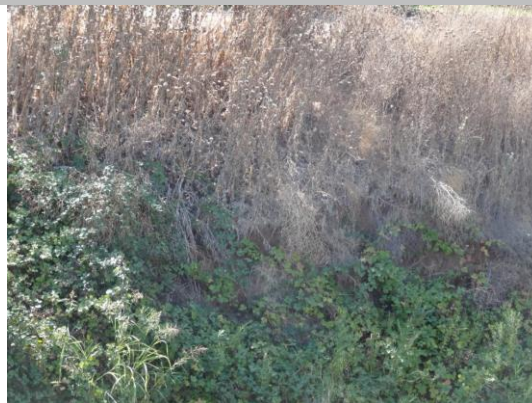
Photo 4 of 4 : FA\_2018\_NA0017\_160\_54\_20181003\_00079.jpg

Close view of the site.

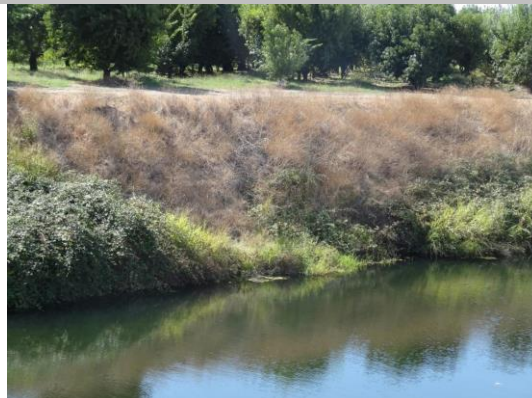
Photo 1 of 4 : FA\_2018\_NA0017\_160\_49\_20181003\_00069.jpg

08/30/2017: No significant change observed.  
 08/16/2016: No significant change observed at the erosion. More vegetation observed at the site.  
 08/12/2015: No significant change observed.  
 08/20/2014: No significant change observed.  
 09/12/2013: No significant change observed.  
 08/22/2012: River-induced erosion occurred on the berm, while the runoff-induced erosion occurred on the levee slope. Site is covered with vegetation. There is no levee structure on site. The levee crest width and levee height were not measured or estimated in the field. [2017 Site ID:NA0017U16RM19.18]

View of the site from right river bank.

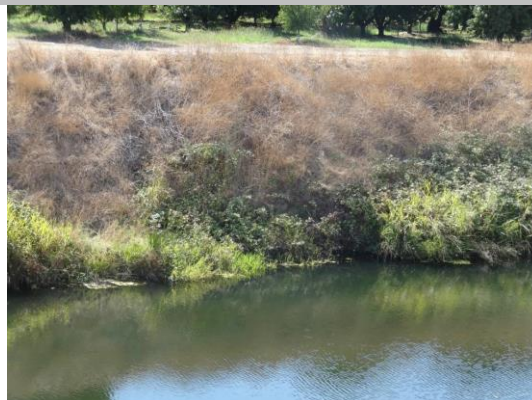
Photo 2 of 4 : FA\_2018\_NA0017\_160\_49\_20181003\_00070.jpg

Close view of the erosion.

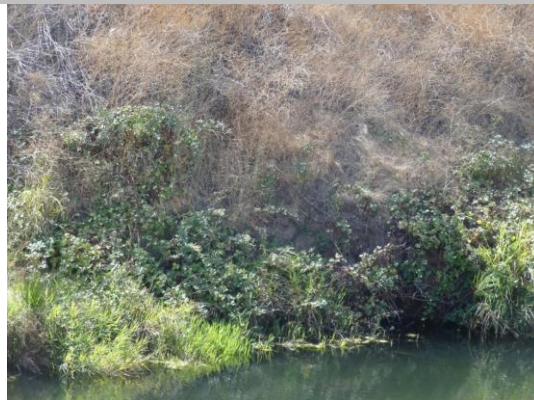
Photo 3 of 4 : FA\_2018\_NA0017\_160\_49\_20181003\_00071.jpg

08/30/2017: No significant change observed.  
 08/16/2016: No significant change observed at the erosion. More vegetation observed at the site.  
 08/12/2015: No significant change observed.  
 08/20/2014: No significant change observed.  
 09/12/2013: No significant change observed.  
 08/22/2012: River-induced erosion occurred on the berm, while the runoff-induced erosion occurred on the levee slope. Site is covered with vegetation. There is no levee structure on site. The levee crest width and levee height were not measured or estimated in the field. [2017 Site ID:NA0017U16RM19.18]

Front view of the erosion at the berm.

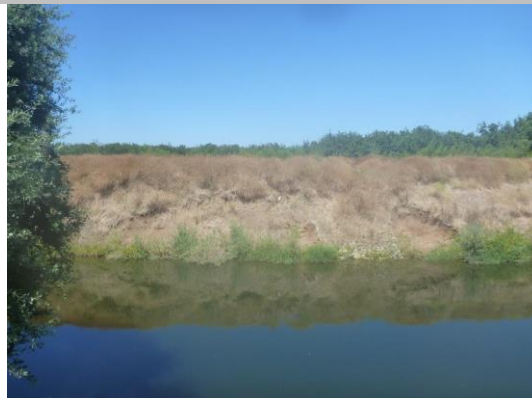
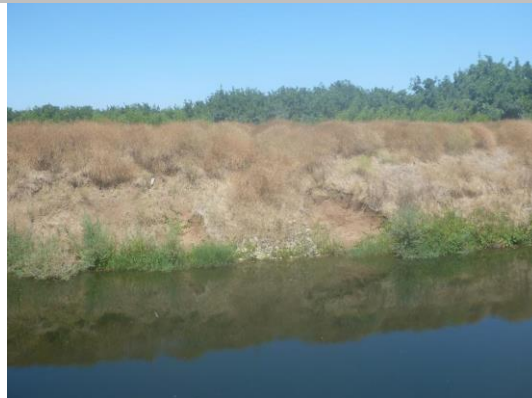
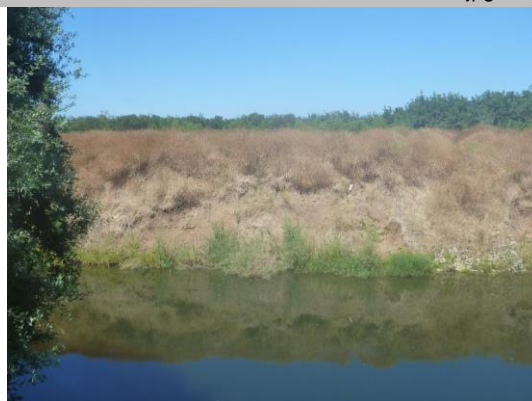
Comment Code					
Inspector Comment					
Levee Evaluation Comments					
Description:Erosion is on the waterside slope; The lat, long above are from the Spring DWR inspection report which took the photo and GPS from the right bank. The erosion is on the left bank.					
Site ID No:475					
Site Designation:LMA-302					
Repair Type: Erosion					
Rating:Area of Concern					
Field Date:7/27/2017					
Notes: Small levee prism which turns into high ground nearby. Very dense vegetation on crown (5 ft tall). Opposite bank is lower than the eroded levee and is designed to flood the nearby orchard. This is thought to be caused by a beaver den and has been cited in past 2 DWR inspections.

Item	2017 Storm Damage			38.012910 °	38.012910 °	
				-121.067996 °	-121.067996 °	
DWR ID	DWR_NA0017_16_f_2017_242					
Comment Code						
Inspector Comment						
Levee Evaluation Comments						
Description:Erosion is on the waterside slope; The lat, long above are from the Spring DWR inspection report which took the photo and GPS from the right bank. The erosion is on the left bank.						
Site ID No:475						
Site Designation:LMA-302						
Repair Type: Erosion						
Rating:Area of Concern						
Field Date:7/27/2017						
Notes: Small levee prism which turns into high ground nearby. Very dense vegetation on crown (5 ft tall). Opposite bank is lower than the eroded levee and is designed to flood the nearby orchard. This is thought to be caused by a beaver den and has been cited in past 2 DWR inspections.

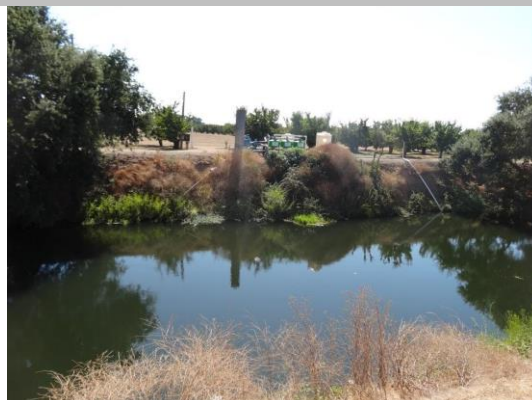
Photo 1 of 4 : FA\_2018\_NA0017\_160\_47\_20181003\_00060.jpg

LM Start	4.16	Rating **	U	Issue No.	47
LM End	4.18	Issue Type +	Ma	Location *	WS
Category	Supplemental			GPS Latitude/Longitude	
				Start	End
Item	DWR Erosion Survey			38.012792 °	38.012792 °
				-121.068073 °	-121.068073 °
DWR ID	NA0017U16RM18.69				
Comment Code					
Inspector Comment					
08/30/2017: New erosion observed at the site, under the irrigation pipe.					
08/16/2016: No significant change observed.					
08/12/2015: No significant change observed.					
08/20/2014: No significant change observed.					
09/12/2013: No significant change observed.					
08/22/2012: An irrigation pipe is present at the site, but probably did not cause the erosion. There is no levee structure on site. The levee crest width and levee height were not measured or estimated in the field.					
[2017 Site ID: NA0017U16RM18.69]

View of the erosion site.

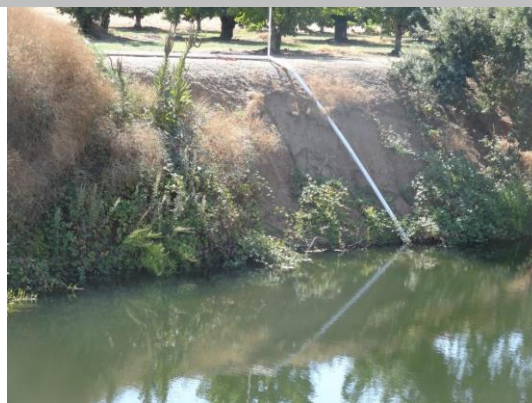
Photo 2 of 4 : FA\_2018\_NA0017\_160\_47\_20181003\_00061.jpg

LM Start	4.16	Rating **	U	Issue No.	47 (cont)	
LM End	4.18	Issue Type +	Ma	Location *	WS	
Category	Supplemental			GPS Latitude/Longitude		
				Start		End
Item	DWR Erosion Survey			38.012792 °		38.012792 °
				-121.068073 °		-121.068073 °
DWR ID	NA0017U16RM18.69					
Comment Code						
Inspector Comment						
08/30/2017: New erosion observed at the site, under the irrigation pipe.						
08/16/2016: No significant change observed.						
08/12/2015: No significant change observed.						
08/20/2014: No significant change observed.						
09/12/2013: No significant change observed.						
08/22/2012: An irrigation pipe is present at the site, but probably did not cause the erosion. There is no levee structure on site. The levee crest width and levee height were not measured or estimated in the field.						
[2017 Site ID:NA0017U16RM18.69]

View of the new erosion under the irrigation pipe.

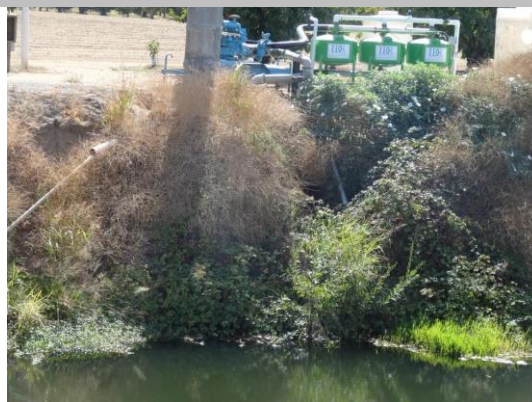
Photo 3 of 4 : FA\_2018\_NA0017\_160\_47\_20181003\_00062.jpg

Close view of the erosion.

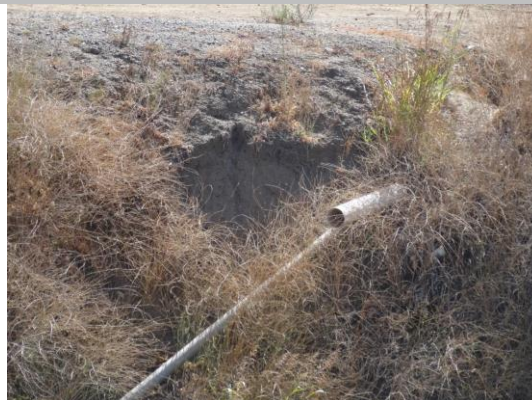
Photo 4 of 4 : FA\_2018\_NA0017\_160\_47\_20181003\_00063.jpg

LM Start	4.16	Rating **	U	Issue No.	47 (cont)	
LM End	4.18	Issue Type +	Ma	Location *	WS	
Category	Supplemental			GPS Latitude/Longitude		
				Start		End
Item	DWR Erosion Survey			38.012792 °		38.012792 °
				-121.068073 °		-121.068073 °
DWR ID	NA0017U16RM18.69					
Comment Code						
Inspector Comment						
08/30/2017: New erosion observed at the site, under the irrigation pipe.						
08/16/2016: No significant change observed.						
08/12/2015: No significant change observed.						
08/20/2014: No significant change observed.						
09/12/2013: No significant change observed.						
08/22/2012: An irrigation pipe is present at the site, but probably did not cause the erosion. There is no levee structure on site. The levee crest width and levee height were not measured or estimated in the field.						
[2017 Site ID:NA0017U16RM18.69]

Close view of the erosion.

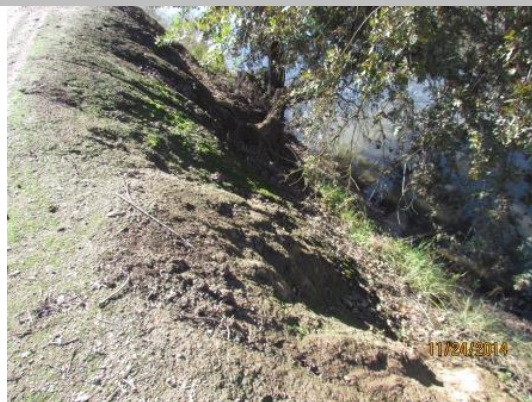
Photo 1 of 2 : FA\_2018\_NA0017\_160\_228\_20181003\_00178.jpg

LM Start	4.20	Rating **	A/W	Issue No.	228
LM End	4.20	Issue Type +	Ma	Location *	WS
Category	Earthen Levee			GPS Latitude/Longitude	
				Start	End
Item	Slope Stability			38.012288 °	38.012288 °
				-121.068239 °	-121.068239 °
DWR ID	DWR_NA0017_16_f_2012_228				
Comment Code					
S1 : Repair slope instability.					
Inspector Comment					
This portion of the levee is non-project. Therefore, an A/W rating was given.

Updated picture of the slope instability on the waterside of the levee looking downstream.

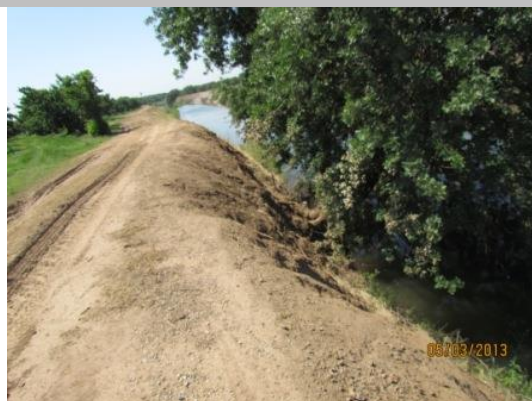
Photo 2 of 2 : FA\_2018\_NA0017\_160\_228\_20181003\_00179.jpg

LM Start	4.20	Rating **	A/W	Issue No.	228 (cont)	
LM End	4.20	Issue Type +	Ma	Location *	WS	
Category	Earthen Levee			GPS Latitude/Longitude		
				Start		End
Item	Slope Stability			38.012288°	38.012288°	
				-121.068239°	-121.068239°	
DWR ID	DWR_NA0017_16_f_2012_228					
Comment Code						
S1 : Repair slope instability.						
Inspector Comment						
This portion of the levee is non-project. Therefore, an A/W rating was given.

Slope instability was found on the waterside shoulder of the levee looking downstream.

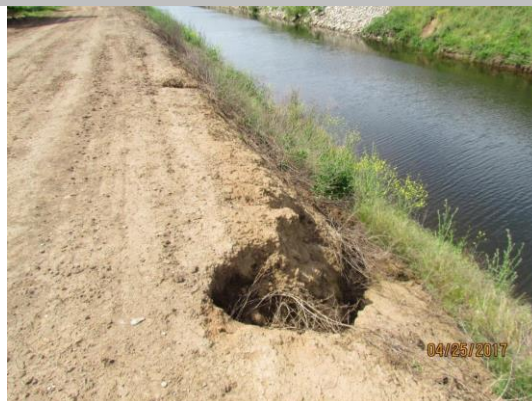
Photo 1 of 2 : FA\_2018\_NA0017\_160\_73\_20181003\_00104.jpg

LM Start	4.27	Rating **	A/W	Issue No.	73
LM End	4.27	Issue Type +	Ma	Location *	WS
Category	Earthen Levee			GPS Latitude/Longitude	
				Start	End
Item	Erosion / Bank Caving			38.011288 °	38.011288 °
				-121.068579 °	-121.068579 °
DWR ID	DWR_NA0017_16_f_2018_73				
Comment Code					
E2 : Schedule repair of erosion site prior to the next inspection.					
Inspector Comment					
The erosion may cut into the access road if it is not repaired.

Updated picture of the erosion on the waterside of the levee. Spring 2017

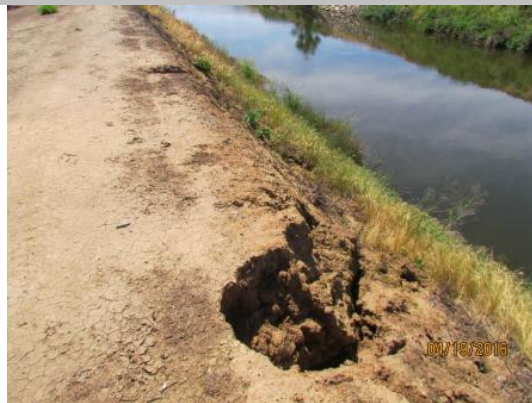
Photo 2 of 2 : FA\_2018\_NA0017\_160\_73\_20181003\_00105.jpg

View of the erosion on the waterside shoulder of the levee during spring 2016 inspection.

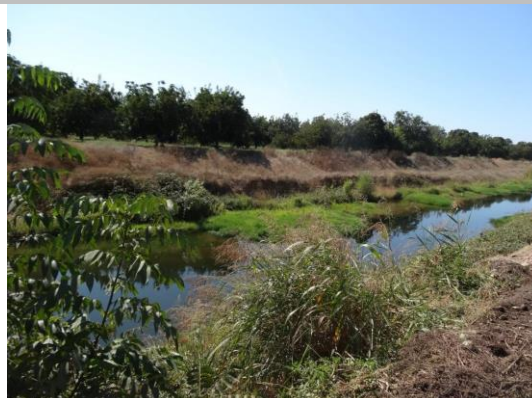
Photo 1 of 4 : FA\_2018\_NA0017\_160\_42\_20181003\_00053.jpg

LM Start	5.33	Rating **	M	Issue No.	42
LM End	5.38	Issue Type +	Ma	Location *	WS
Category	Supplemental			GPS Latitude/Longitude	
				Start	End
Item	DWR Erosion Survey			37.997720 °	37.997720 °
				-121.077807 °	-121.077807 °
DWR ID	NA0017U16RM17.81				
Comment Code					
Inspector Comment					
08/30/2017: No significant change observed.					
08/16/2016: No significant change observed.					
08/12/2015: No significant change observed.					
08/20/2014: No significant change observed.					
09/12/2013: No significant change observed.					
08/22/2012: The site is located at the opposite river bank of E. Tobacco Road. There is no levee structure on site. The levee crest width and levee height were not measured or estimated in the field. [2017 Site ID:NA0017U16RM17.81]

Upstream view of the site from right river bank.

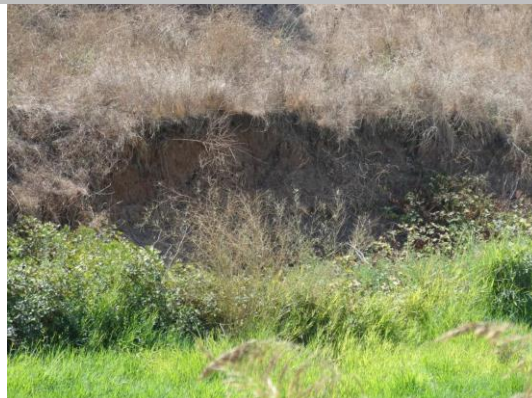
Photo 3 of 4 : FA\_2018\_NA0017\_160\_42\_20181003\_00055.jpg

LM Start	5.33	Rating **	M	Issue No.	42 (cont)	
LM End	5.38	Issue Type +	Ma	Location *	WS	
Category	Supplemental			GPS Latitude/Longitude		
				Start		End
Item	DWR Erosion Survey			37.997720 °		37.997720 °
				-121.077807 °		-121.077807 °
DWR ID	NA0017U16RM17.81					
Comment Code						
Inspector Comment						
08/30/2017: No significant change observed.						
08/16/2016: No significant change observed.						
08/12/2015: No significant change observed.						
08/20/2014: No significant change observed.						
09/12/2013: No significant change observed.						
08/22/2012: The site is located at the opposite river bank of E. Tobacco Road. There is no levee structure on site. The levee crest width and levee height were not measured or estimated in the field. [2017 Site ID:NA0017U16RM17.81]

Close view of the erosion.

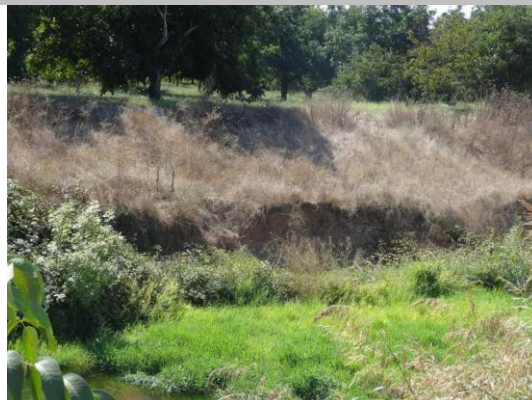
Photo 4 of 4 : FA\_2018\_NA0017\_160\_42\_20181003\_00056.jpg

Close view of the erosion.

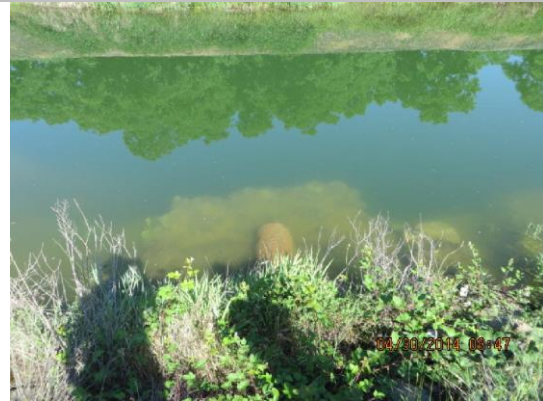
Photo 1 of 3 : UCIP\_FA\_2018\_35686\_64327.jpg

LM Start	5.48	Rating **	M	Issue No.	814
LM End	5.48	Issue Type +	Ma	Location *	
Category	Supplemental			GPS Latitude/Longitude	
				Start	End
Item	DWR UCIP LMA Responsibility			37.996132 °	37.996132 °
				-121.079127 °	-121.079127 °
DWR ID	23332				
Comment Code					
Inspector Comment					
FS_ID:35686					
DS_ID:23332					
EP_NO: N/A					
Repair Type: Non-Urgent					
Crossing Status: Found					
UCIP Comments: Pipe appears abandoned and if so should be done so properly. LS of pipe is buried and WS is badly rusted. Pipe should be inspected internally.					
FIELD_STRUCT_DESC: *ABANDONED* 18-inch corrugated metal drainage pipe through the levee, 3 feet below the crown. Grout over pipe in channel with pipe open and visible in water at the WS toe.					
[Additional Reference(s): DWR Levee Log, 1992. USACE San Joaquin O&M Manual 611.1, Volume F, (HLM 5.69)].					
FS Date: 4/30/2014

Pipe visible in water at WS toe.

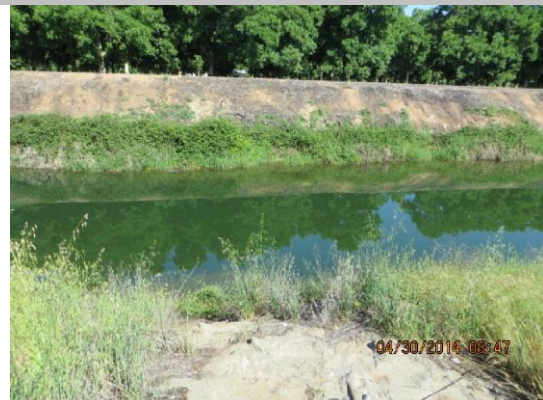
Photo 2 of 3 : UCIP\_FA\_2018\_35686\_64326.jpg

Grout over pipe in channel on WS.

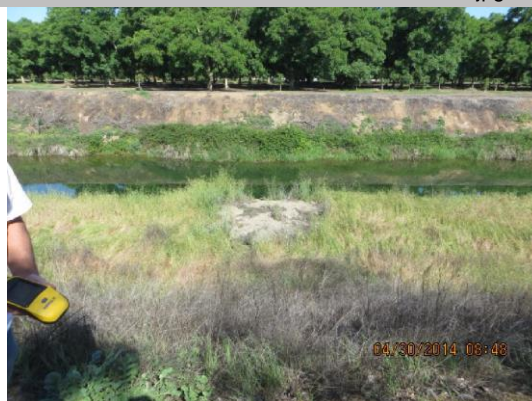
Photo 3 of 3 : UCIP\_FA\_2018\_35686\_64325.jpg

Comment Code						
Inspector Comment						
FS_ID:35686						
DS_ID:23332						
EP_NO: N/A						
Repair Type: Non-Urgent						
Crossing Status: Found						
UCIP Comments: Pipe appears abandoned and if so should be done so properly. LS of pipe is burried and WS is badly rusted. Pipe should be inspected internally.						
FIELD_STRUCT_DESC: *ABANDONED* 18-inch corrugated metal drainage pipe through the levee, 3 feet below the crown. Grout over pipe in channel with pipe open and visible in water at the WS toe.						
[Additional Reference(s): DWR Levee Log, 1992. USACE San Joaquin O&M Manual 611.1, Volume F, (HLM 5.69)].						
FS Date: 4/30/2014

Grout over pipe in channel on WS.

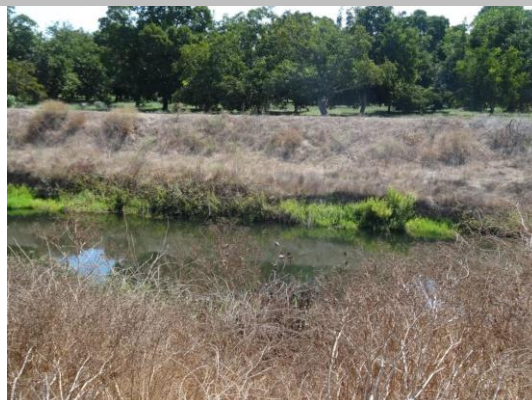
Photo 1 of 4 : FA\_2018\_NA0017\_160\_41\_20181003\_00049.jpg

LM Start	5.56	Rating **	U	Issue No.	41
LM End	5.58	Issue Type +	Ma	Location *	WS
Category	Supplemental			GPS Latitude/Longitude	
				Start	End
Item	DWR Erosion Survey			37.995216 °	37.995216 °
				-121.080159 °	-121.080159 °
DWR ID	NA0017U16RM17.27				
Comment Code					
Inspector Comment					
08/30/2017: No significant change observed.					
08/16/2016: No significant change observed.					
08/12/2015: No significant change observed.					
08/20/2014: No significant change observed.					
09/12/2013: The erosion seems to be caused by high river flow. Dense vegetation is present at the site. Signs of animal activities are visible.					
There is no levee structure on site. The levee crest width and levee height were not measured or estimated in the field. [2017 Site ID:NA0017U16RM17.27]

View of the erosion from right river bank.

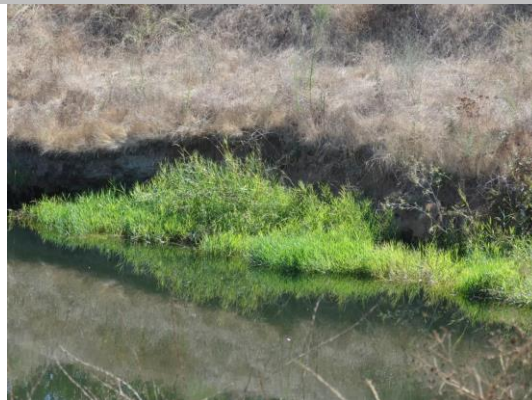
Photo 2 of 4 : FA\_2018\_NA0017\_160\_41\_20181003\_00050.jpg

Close view of the erosion site.

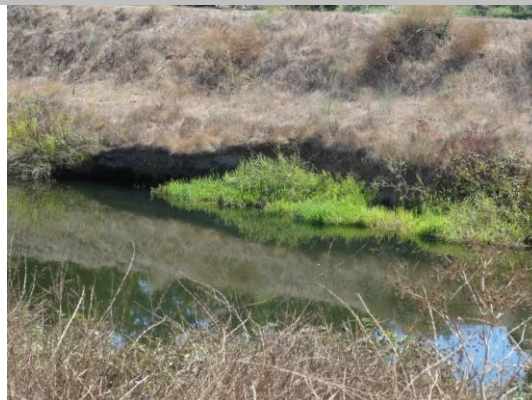
Photo 3 of 4 : FA\_2018\_NA0017\_160\_41\_20181003\_00051.jpg

Close view of the erosion.

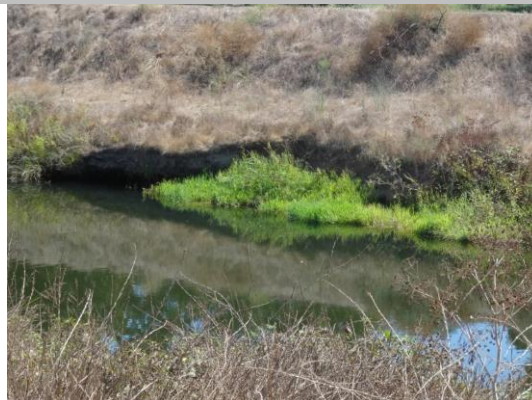
Photo 4 of 4 : FA\_2018\_NA0017\_160\_41\_20181003\_00052.jpg

LM Start	5.56	Rating **	U	Issue No.	41 (cont)	
LM End	5.58	Issue Type +	Ma	Location *	WS	
Category	Supplemental			GPS Latitude/Longitude		
				Start		End
Item	DWR Erosion Survey			37.995216 °		37.995216 °
				-121.080159 °		-121.080159 °
DWR ID	NA0017U16RM17.27					
Comment Code						
Inspector Comment						
08/30/2017: No significant change observed.						
08/16/2016: No significant change observed.						
08/12/2015: No significant change observed.						
08/20/2014: No significant change observed.						
09/12/2013: The erosion seems to be caused by high river flow. Dense vegetation is present at the site. Signs of animal activities are visible.						
There is no levee structure on site. The levee crest width and levee height were not measured or estimated in the field. [2017 Site ID:NA0017U16RM17.27]

Close view of the erosion.

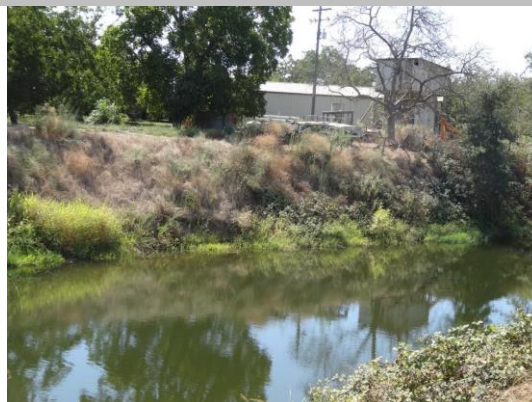
Photo 1 of 4 : FA\_2018\_NA0017\_160\_40\_20181003\_00045.jpg

LM Start	5.71	Rating **	M	Issue No.	40
LM End	5.72	Issue Type +	Ma	Location *	WS
Category	Supplemental			GPS Latitude/Longitude	
				Start	End
Item	DWR Erosion Survey			37.993525 °	37.993525 °
				-121.081679 °	-121.081679 °
DWR ID	NA0017U16RM17.11				
Comment Code					
Inspector Comment					
08/30/2017: No significant change observed.					
08/16/2016: No significant change observed.					
08/12/2015: No significant change observed.					
08/20/2014: The erosion is near a tree and probably has been made worse by the unstable bank slope. [2017 Site ID:NA0017U16RM17.11]

View of the site from right river bank.

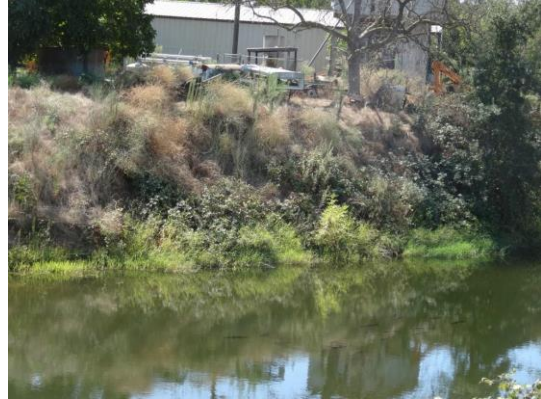
Photo 2 of 4 : FA\_2018\_NA0017\_160\_40\_20181003\_00046.jpg

Close view of the erosion.

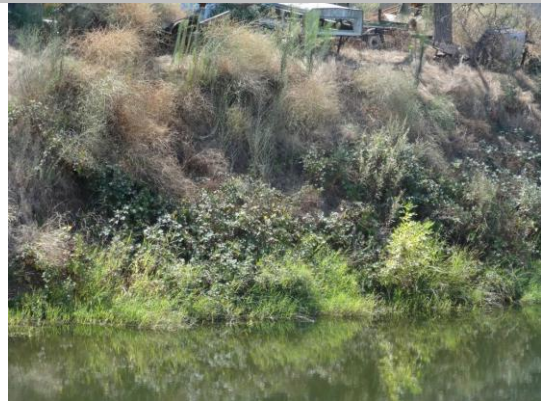
Photo 3 of 4 : FA\_2018\_NA0017\_160\_40\_20181003\_00047.jpg

Close view of the erosion.

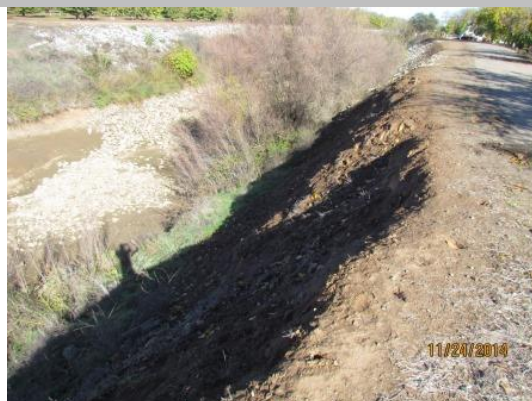
Photo 1 of 1 : FA\_2018\_NA0017\_160\_264\_20181003\_00199.jpg

LM Start	5.87	Rating **	A/W	Issue No.	264
LM End	5.87	Issue Type +	Ma	Location *	WS
Category	Earthen Levee			GPS Latitude/Longitude	
				Start	End
Item	Slope Stability			37.991628 °	37.991628 °
				-121.083312 °	-121.083312 °
DWR ID	DWR_NA0017_16_f_2014_264				
Comment Code					
S1 : Repair slope instability.					
Inspector Comment					
This portion of the levee is non-project. Therefore, an A/W rating was given.

A slope instability was found on the waterside of the levee looking upstream.

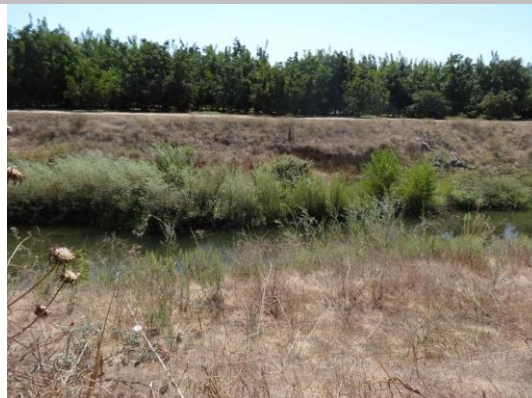
Photo 1 of 4 : FA\_2018\_NA0017\_160\_39\_20181003\_00041.jpg

LM Start	6.49	Rating **	U	Issue No.	39
LM End	6.68	Issue Type +	Ma	Location *	WS
Category	Supplemental			GPS Latitude/Longitude	
				Start	End
Item	DWR Erosion Survey			37.983279 °	37.983279 °
				-121.090843 °	-121.090843 °
DWR ID	NA0017U16RM16.27				
Comment Code					
Inspector Comment					
08/30/2017: No significant change observed.					
08/16/2016: No significant change observed.					
08/12/2015: No significant change observed.					
08/20/2014: No significant change observed.					
09/12/2013: Site has been surveyed and the erosion has worsened since last year.					
08/22/2012: Discontinuous scarp or pocket erosions occurred along a long stretch of the river, with an erosion height greater than 25 ft. at certain points. There is no levee structure on site. The levee crest width and levee height were not measured or estimated in the field. [2017 Site ID:NA0017U16RM16.27]

Upstream view of the site from right river bank.

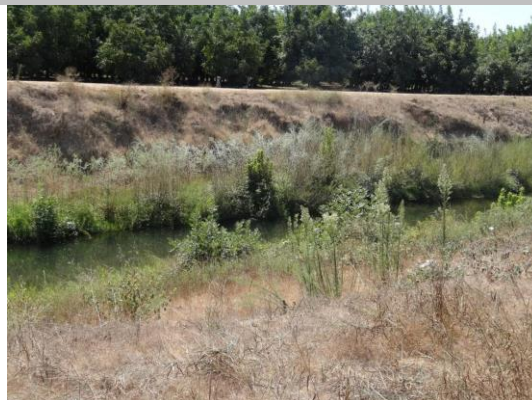
Photo 2 of 4 : FA\_2018\_NA0017\_160\_39\_20181003\_00042.jpg

Close view of the erosion.

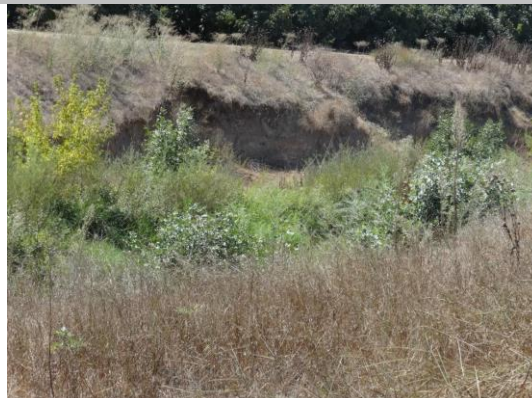
Photo 3 of 4 : FA\_2018\_NA0017\_160\_39\_20181003\_00043.jpg

Comment Code						
Inspector Comment						
08/30/2017: No significant change observed.						
08/16/2016: No significant change observed.						
08/12/2015: No significant change observed.						
08/20/2014: No significant change observed.						
09/12/2013: Site has been surveyed and the erosion has worsened since last year.						
08/22/2012: Discontinuous scarp or pocket erosions occurred along a long stretch of the river, with an erosion height greater than 25 ft. at certain points. There is no levee structure on site. The levee crest width and levee height were not measured or estimated in the field. [2017 Site ID:NA0017U16RM16.27]

Front view of the erosion.

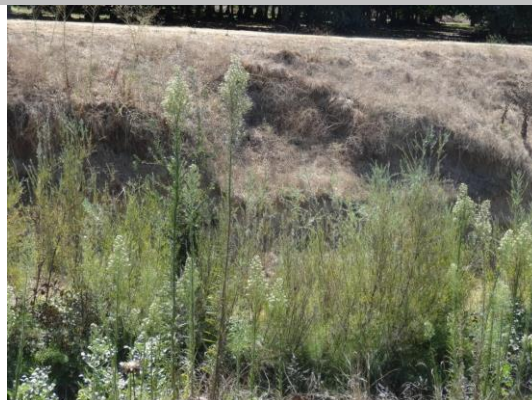
Photo 4 of 4 : FA\_2018\_NA0017\_160\_39\_20181003\_00044.jpg

Close view of the erosion.

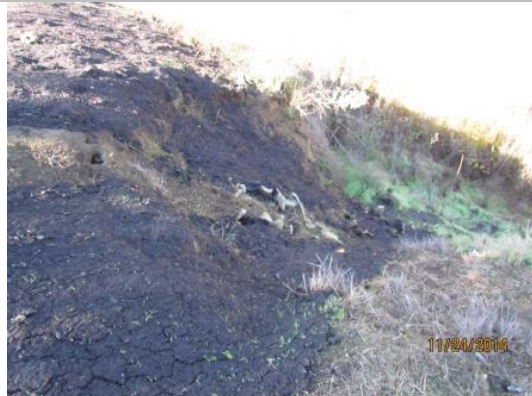
Photo 1 of 2 : FA\_2018\_NA0017\_160\_120\_20181003\_00149.jpg

LM Start	6.70	Rating **	A/W	Issue No.	120
LM End	6.70	Issue Type +	Ma	Location *	WS
Category	Earthen Levee			GPS Latitude/Longitude	
				Start	End
Item	Slope Stability			37.982299 °	37.982299 °
				-121.092665 °	-121.092665 °
DWR ID	DWR_NA0017_16_s_2014_120				
Comment Code					
S1 : Repair slope instability.					
Inspector Comment					
This portion of the levee is non-project. Therefore, an A/W rating was given.

Updated picture of the slope instability on the waterside of the levee looking downstream.

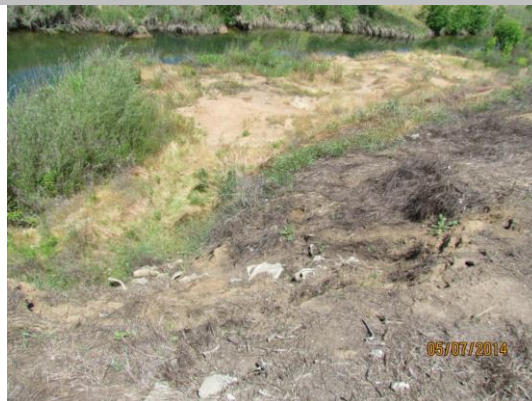
Photo 2 of 2 : FA\_2018\_NA0017\_160\_120\_20181003\_00150.jpg

Slope instability was found on the waterside of the levee looking upstream.

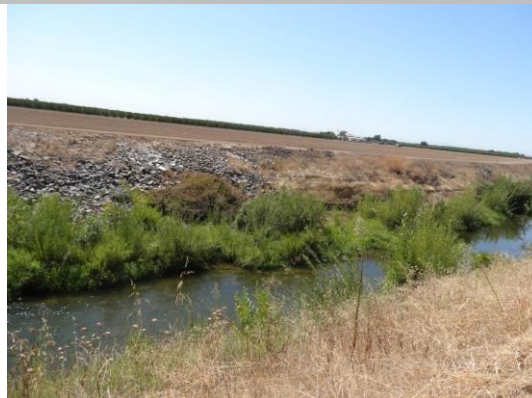
Photo 1 of 4 : FA\_2018\_NA0017\_160\_38\_20181003\_00037.jpg

View of the site from right river bank.

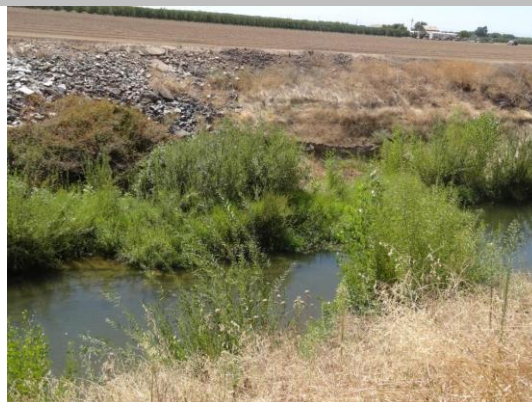
Photo 2 of 4 : FA\_2018\_NA0017\_160\_38\_20181003\_00038.jpg

Close view of the erosion.

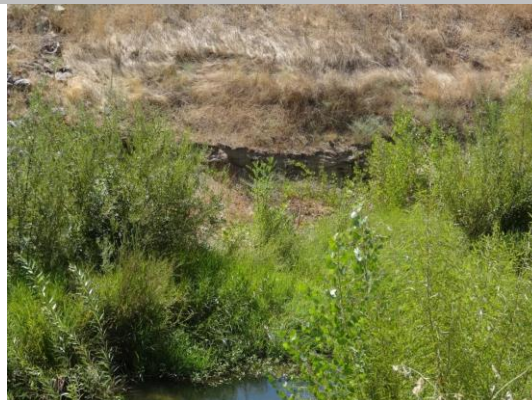
Photo 3 of 4 : FA\_2018\_NA0017\_160\_38\_20181003\_00039.jpg

Close view of the erosion.

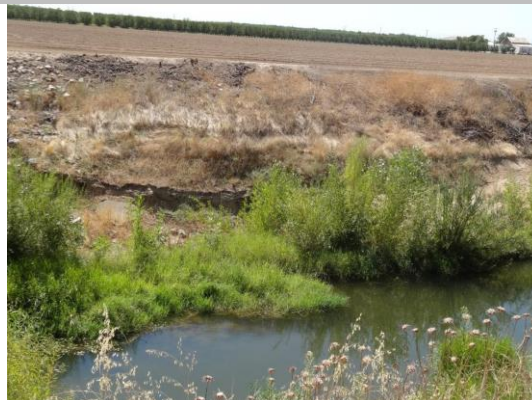
Photo 4 of 4 : FA\_2018\_NA0017\_160\_38\_20181003\_00040.jpg

Close view of the erosion.

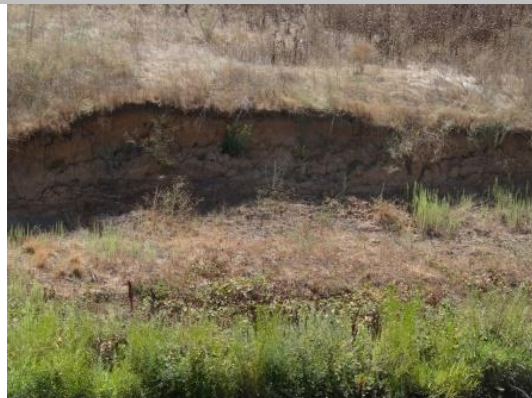
Photo 3 of 4 : FA\_2018\_NA0017\_160\_37\_20181003\_00035.jpg

Close view of the erosion.
