**Flood Control Project Maintenance  
Levee Inspections**

**Maintenance Issue Types Only, Levee Inspection Report By Mile - Fall 2018**

**San Joaquin County Flood Control and Water Conservation District**

Waterway	Bank	Unit Miles	Inspection Start/End	Inspector
Unit No. 01 Littlejohn Creek	Left	2.59	10/18/2018 10/18/2018	Wade Wylie

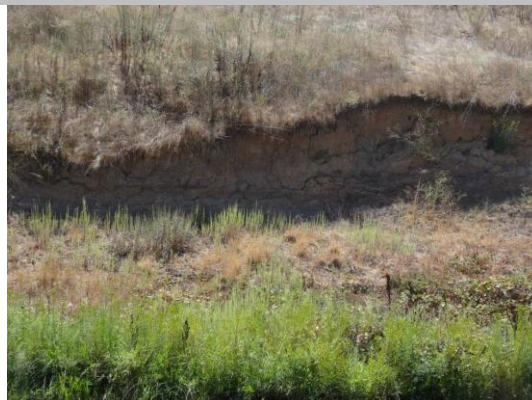
Photo 4 of 4 : FA\_2018\_NA0017\_160\_37\_20181003\_00036.jpg

Close view of the erosion.

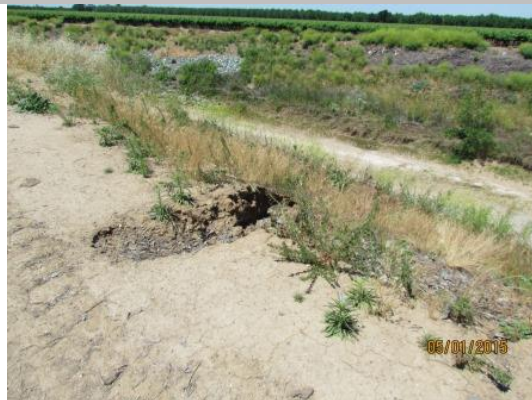
Photo 1 of 1 : FA\_2018\_NA0017\_160\_248\_20181003\_00191.jpg

LM Start	8.68	Rating **	A/W	Issue No.	248
LM End	8.68	Issue Type +	Ma	Location *	WS
Category	Earthen Levee			GPS Latitude/Longitude	
				Start	End
Item	Erosion / Bank Caving			37.968169 °	37.968169 °
				-121.122047 °	-121.122047 °
DWR ID	DWR_NA0017_16_s_2015_248				
Comment Code					
E1 : Note and monitor erosion site.					
Inspector Comment					
Erosion may cut into the access road.

Erosion was found on the waterside looking downstream.

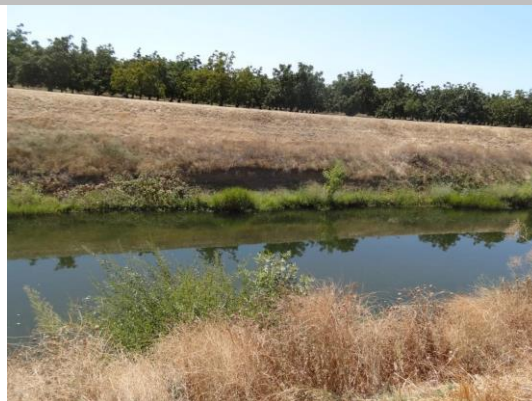
Photo 1 of 4 : FA\_2018\_NA0017\_160\_36\_20181003\_00029.jpg

Front view of the erosion.

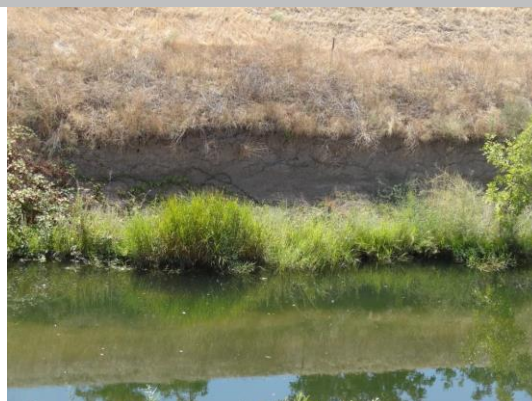
Photo 2 of 4 : FA\_2018\_NA0017\_160\_36\_20181003\_00030.jpg

Close view of the erosion.

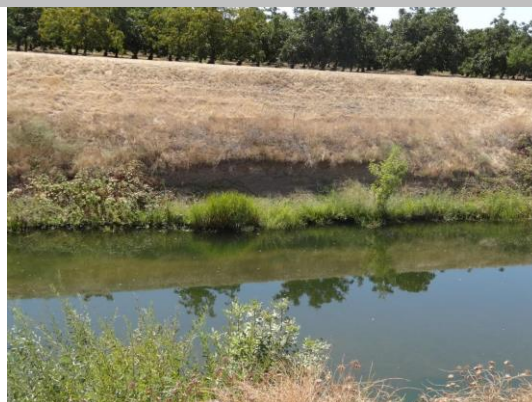
Photo 3 of 4 : FA\_2018\_NA0017\_160\_36\_20181003\_00031.jpg

Close view of the erosion.

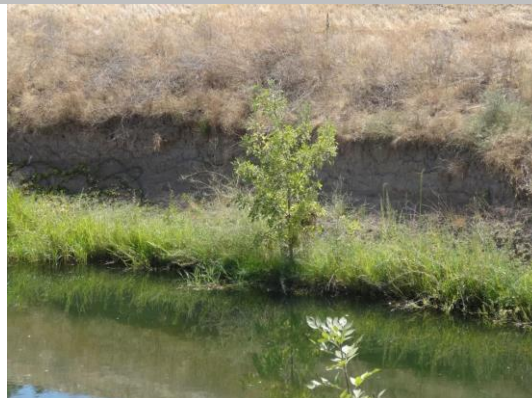
Photo 4 of 4 : FA\_2018\_NA0017\_160\_36\_20181003\_00032.jpg

Close view of the erosion. Note the dense vegetation at the site.

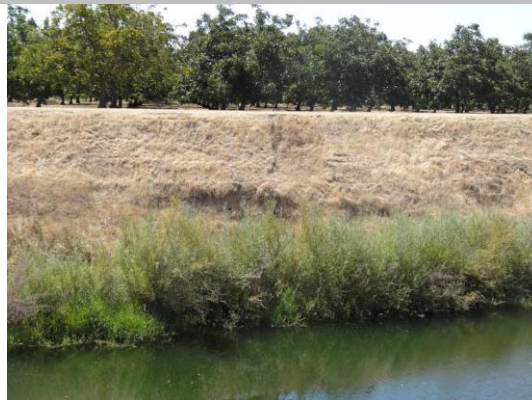
Photo 1 of 4 : FA\_2018\_NA0017\_160\_27\_20181003\_00023.jpg

View of the site from right river bank.

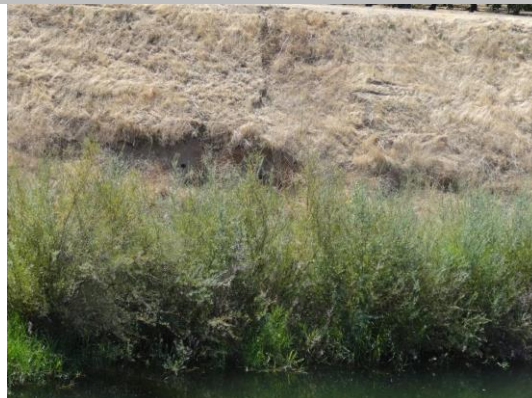
Photo 2 of 4 : FA\_2018\_NA0017\_160\_27\_20181003\_00024.jpg

Close view of the erosion.

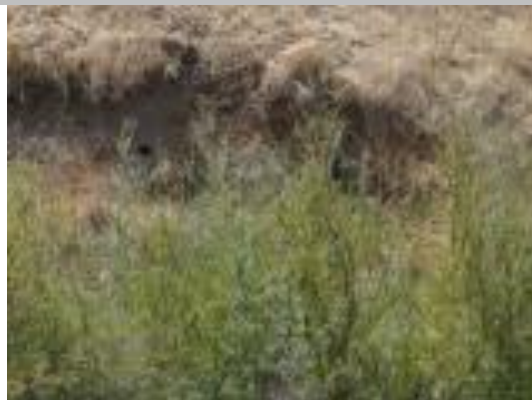
Photo 3 of 4 : FA\_2018\_NA0017\_160\_27\_20181003\_00025.jpg

Close view of the erosion.

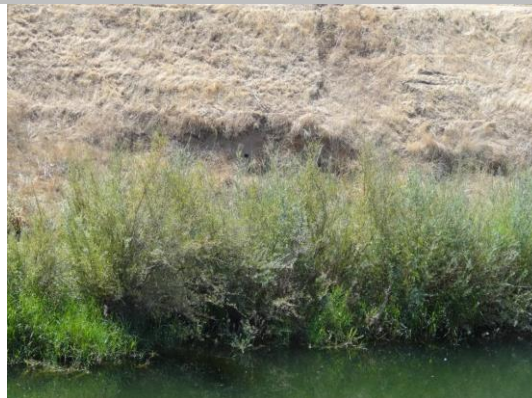
Photo 4 of 4 : FA\_2018\_NA0017\_160\_27\_20181003\_00026.jpg

Close view of the erosion.

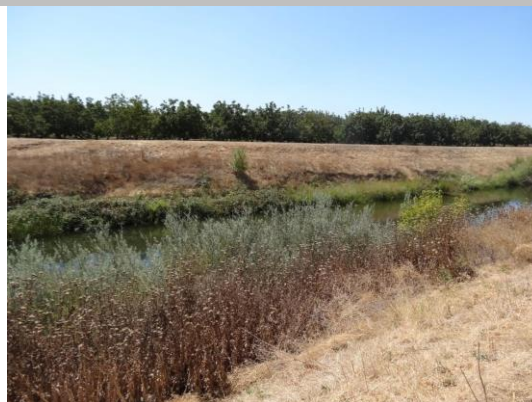
Photo 1 of 4 : FA\_2018\_NA0017\_160\_18\_20181003\_00014.jpg

Upstream view of the erosion.

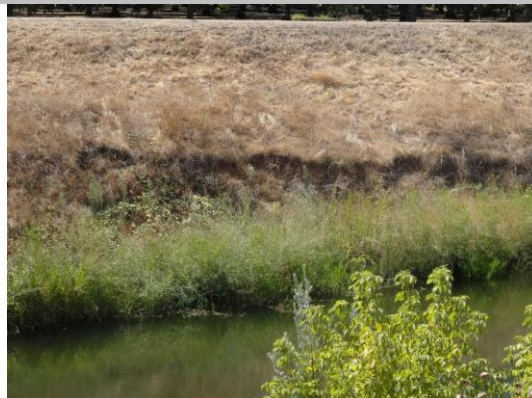
Photo 2 of 4 : FA\_2018\_NA0017\_160\_18\_20181003\_00015.jpg

Close view of the erosion.

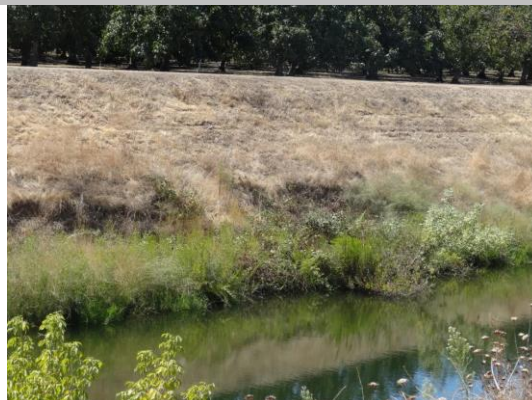
Photo 3 of 4 : FA\_2018\_NA0017\_160\_18\_20181003\_00016.jpg

Close view of the erosion.

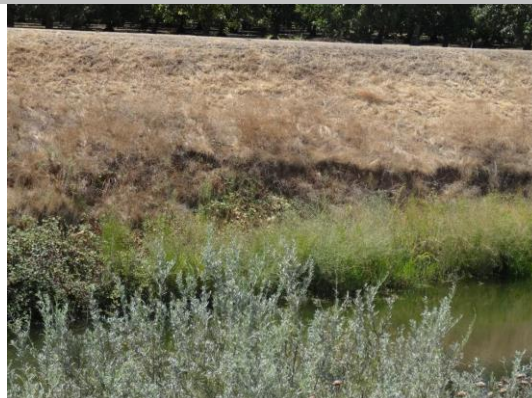
Photo 4 of 4 : FA\_2018\_NA0017\_160\_18\_20181003\_00017.jpg

Front view of the erosion.

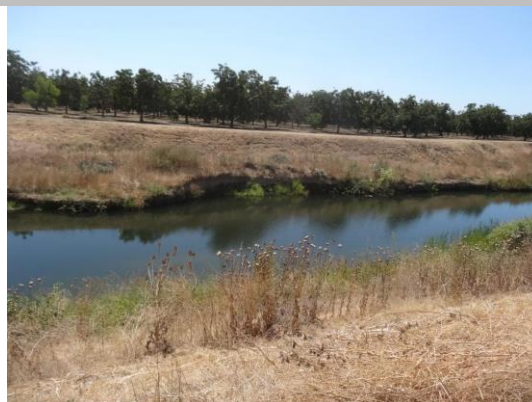
Photo 1 of 3 : FA\_2018\_NA0017\_160\_14\_20181003\_00010.jpg

Upstream view of the erosion.

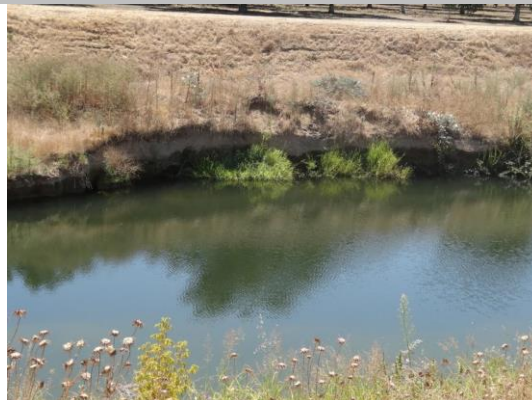
Photo 2 of 3 : FA\_2018\_NA0017\_160\_14\_20181003\_00011.jpg

Close view of the erosion.

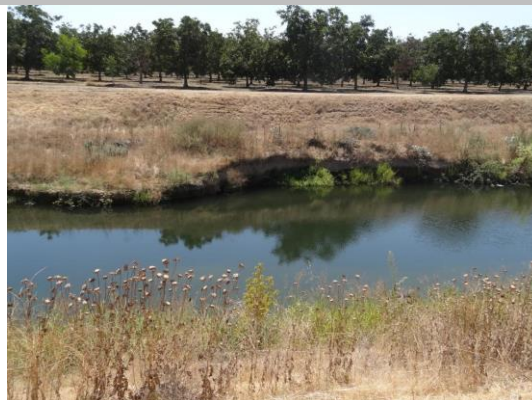
Photo 3 of 3 : FA\_2018\_NA0017\_160\_14\_20181003\_00012.jpg

Close view of the erosion.

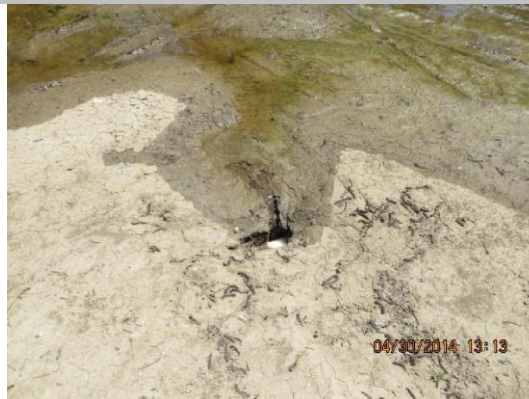
Photo 1 of 3 : UCIP\_FA\_2018\_36144\_65406.jpg

LM Start	9.48	Rating **	M	Issue No.	829
LM End	9.48	Issue Type +	Ma	Location *	
Category	Supplemental			GPS Latitude/Longitude	
				Start	End
Item	DWR UCIP LMA Responsibility			37.965880 °	37.965880 °
				-121.135897 °	-121.135897 °
DWR ID	23344				
Comment Code					
Inspector Comment					
FS_ID:36144 DS_ID:23344 EP_NO: N/A Repair Type: Non-Urgent Crossing Status: Found UCIP Comments: Inlet appears to be burried with soil on LS. Pipe heavily corroded at outlet on WS toe. Good candidate for video inspection. FIELD_STRUCT_DESC: 18-inch corrugated metal drainage pipe, 3.5 feet below the roadway. Grouted spillway and inlet. [Additional Reference(s): DWR Levee Log, 1992. USACE San Joaquin O&M Manual 611.1, Volume F, (HLM 9.77)]. FS Date: 4/30/2014

Inlet on LS shoulder burried in soil.

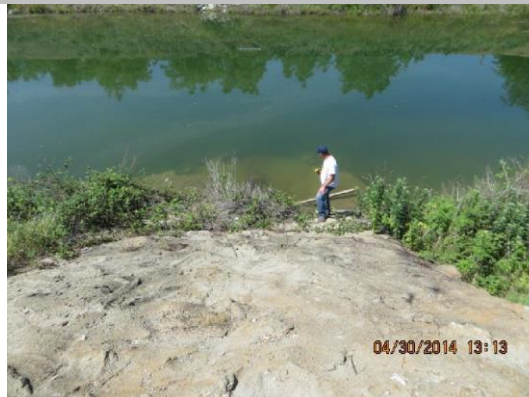
Photo 2 of 3 : UCIP\_FA\_2018\_36144\_65405.jpg

Grout over pipe on WS slope with pipe visible in water at WS toe.

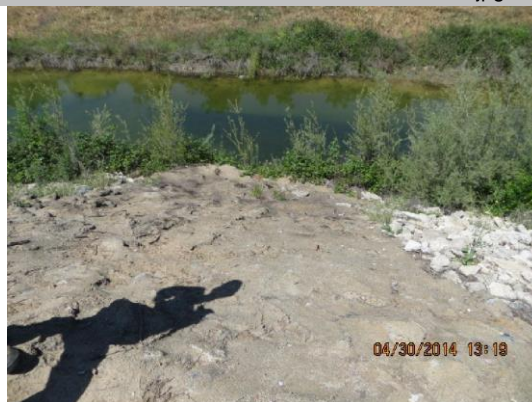
Photo 1 of 3 : UCIP\_FA\_2018\_36145\_65409.jpg

LM Start	9.78	Rating **	M	Issue No.	830	
LM End	9.78	Issue Type +	Ma	Location *		
Category	Supplemental			GPS Latitude/Longitude		
				Start	End	
Item	DWR UCIP LMA Responsibility			37.964912 °	37.964912 °	
				-121.140827 °	-121.140827 °	
DWR ID	23345					
Comment Code						
Inspector Comment						
FS_ID:36145						
DS_ID:23345						
EP_NO: N/A						
Repair Type: Non-Urgent						
Crossing Status: Found						
UCIP Comments: Inlet on LS buried in soil.						
FIELD_STRUCT_DESC: 18-inch corrugated metal drainage pipe						
through the levee, 3.5 feet below the crown. Grouted spillway and inlet.						
[Additional Reference(s): DWR Levee Log, 1992. USACE San Joaquin						
O&M Manual 611.1, Volume F, (HLM 10.07)].						
FS Date: 4/30/2014

Grout over pipe on WS slope.

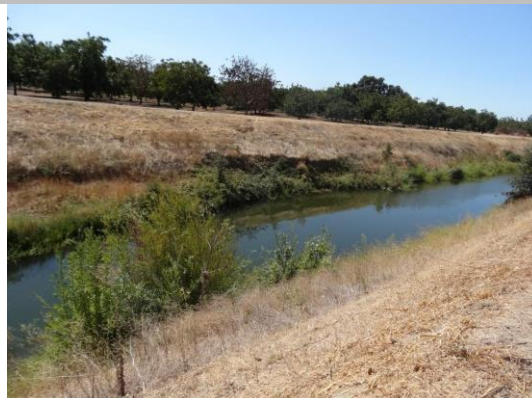
Photo 1 of 4 : FA\_2018\_NA0017\_160\_10\_20181003\_00003.jpg

LM Start	9.86	Rating **	M	Issue No.	10
LM End	9.88	Issue Type +	Ma	Location *	WS
Category	Supplemental			GPS Latitude/Longitude	
				Start	End
Item	DWR Erosion Survey			37.964735 °	37.964735 °
				-121.142503 °	-121.142503 °
DWR ID	NA0017U16RM12.95				
Comment Code					
Inspector Comment					
08/30/2017: No significant change observed.					
08/16/2016: No significant change observed.					
08/12/2015: No significant change observed.					
08/20/2014: No significant change observed.					
09/12/2013: No significant change observed.					
08/22/2012: Dense vegetation on site. There is no levee structure on site. The levee crest width and levee height were not measured or estimated in the field. [2017 Site ID:NA0017U16RM12.95]

Upstream view of the site from right river bank.

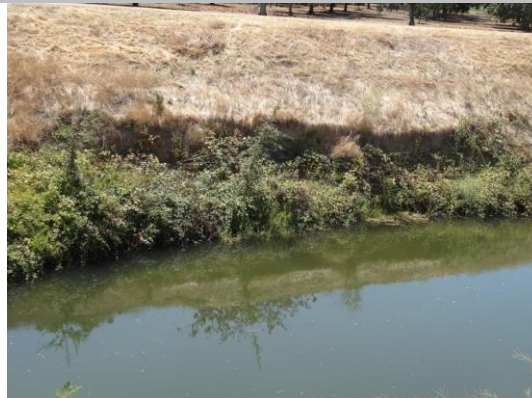
Photo 2 of 4 : FA\_2018\_NA0017\_160\_10\_20181003\_00004.jpg

Close view of the erosion.

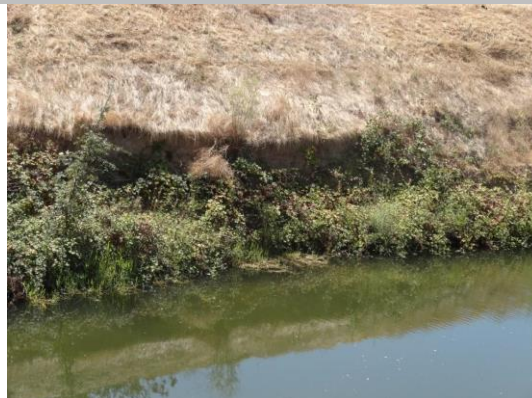
Photo 3 of 4 : FA\_2018\_NA0017\_160\_10\_20181003\_00005.jpg

Close view of the erosion.

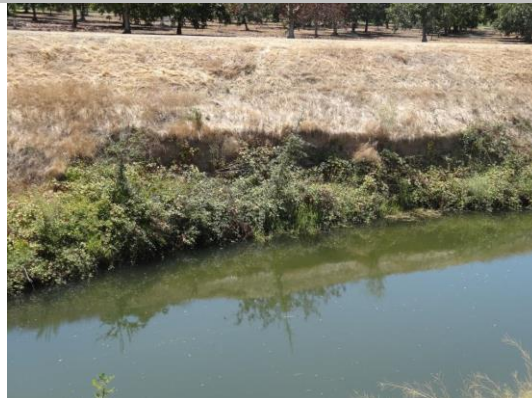
Photo 4 of 4 : FA\_2018\_NA0017\_160\_10\_20181003\_00006.jpg

Close view of the erosion.

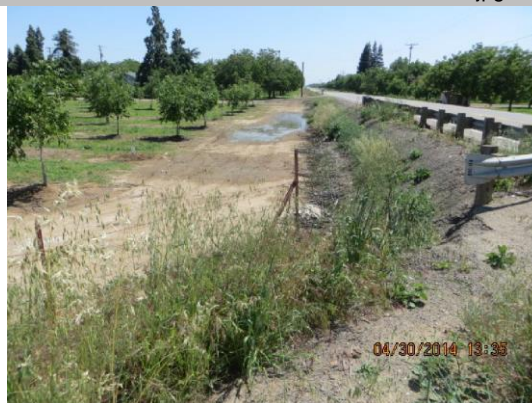
Photo 2 of 3 : UCIP\_FA\_2018\_36163\_65441.jpg

Pipe and headwall visible at LS toe.

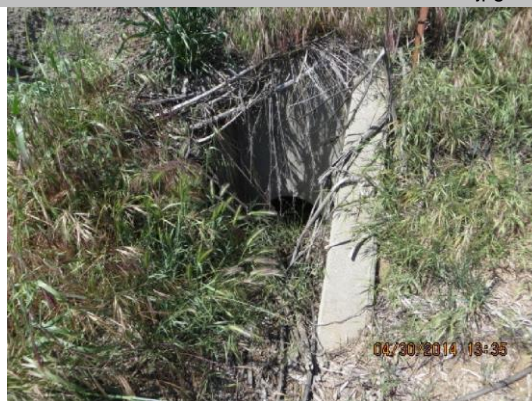
Photo 3 of 3 : UCIP\_FA\_2018\_36163\_65440.jpg

Headwall and pipe with heavy sediment buildup on LS toe.

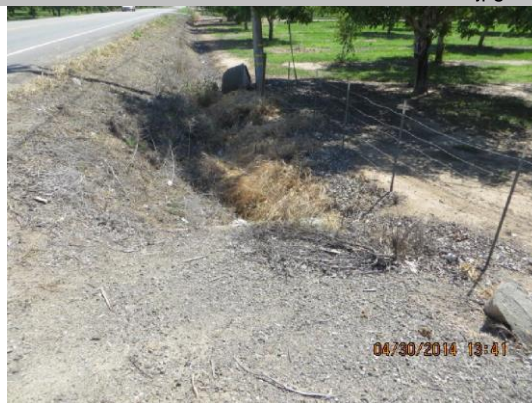
Photo 1 of 3 : UCIP\_FA\_2018\_36164\_65445.jpg

LM Start	10.21	Rating **	A/W	Issue No.	834
LM End	10.21	Issue Type +	Ma	Location *	
Category	Supplemental			GPS Latitude/Longitude	
				Start	End
Item	DWR UCIP LMA Responsibility			37.964660 °	37.964660 °
				-121.148660 °	-121.148660 °
DWR ID	23348				
Comment Code					
Inspector Comment					
FS_ID:36164 DS_ID:23348 EP_NO: N/A Repair Type: No Action Needed Crossing Status: Found UCIP Comments: FIELD_STRUCT_DESC: 18-inch corrugated metal drainage pipe through the levee, 6 feet below the crown. Concrete headwall on the landside (LS). Flap gate on the waterside (WS). [Additional Reference(s): DWR Levee Log, 1992. USACE San Joaquin O&M Manual 611.1, Volume F, (HLM 10.51)]. FS Date: 4/30/2014

Pipe and concrete headwall on LS toe.

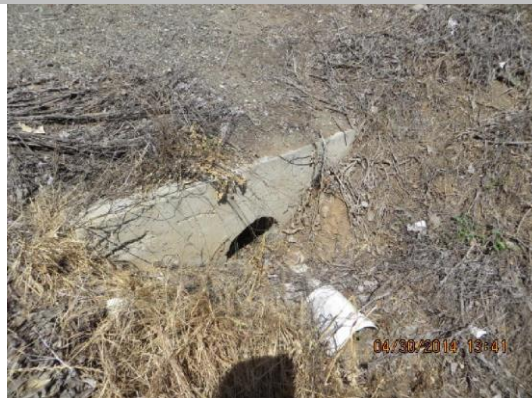
Photo 2 of 3 : UCIP\_FA\_2018\_36164\_65444.jpg

Pipe and concrete headwall on LS toe. Sediment buildup on LS toe.

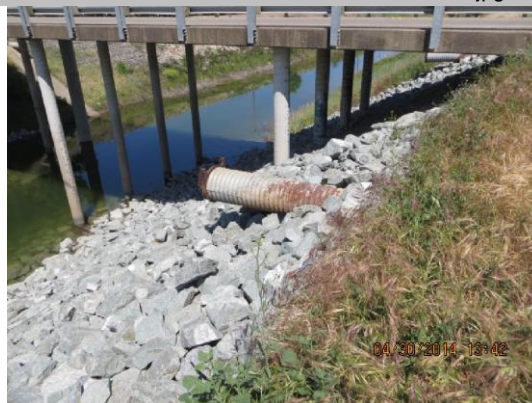
Photo 3 of 3 : UCIP\_FA\_2018\_36164\_65443.jpg

Pipe and flapgate visible on WS slope.

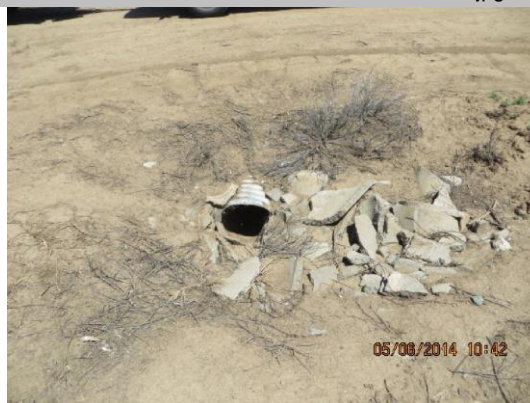
Photo 1 of 2 : UCIP\_FA\_2018\_36186\_65505.jpg

LM Start	11.08	Rating **	A/W	Issue No.	841
LM End	11.08	Issue Type +	Ma	Location *	
Category	Supplemental			GPS Latitude/Longitude	
				Start	End
Item	DWR UCIP LMA Responsibility			37.960565°	37.960565°
				-121.163287°	-121.163287°
DWR ID	23354				
Comment Code					
Inspector Comment					
FS_ID:36186					
DS_ID:23354					
EP_NO: N/A					
Repair Type: No Action Needed					
Crossing Status: Found					
UCIP Comments:					
FIELD_STRUCT_DESC: 18-inch corrugated metal drainage pipe					
through the levee, 3.5 feet below the roadway. Grouted spillway.					
[Additional Reference(s): DWR Levee Log, 1992. USACE San Joaquin					
O&M Manual 611.1, Volume F, (HLM 11.41)].					
FS Date: 5/6/2014

Pipe at inlet on LS toe.

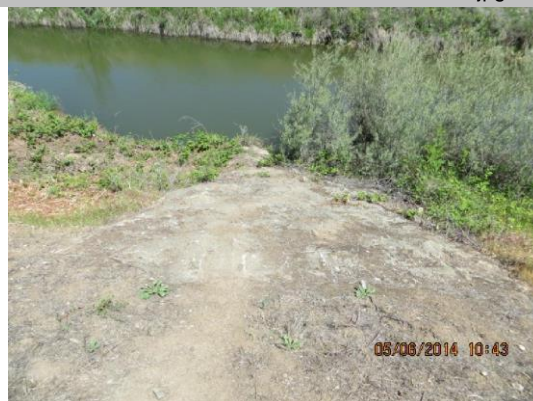
Photo 2 of 2 : UCIP\_FA\_2018\_36186\_65504.jpg

Grout over pipe on WS slope.

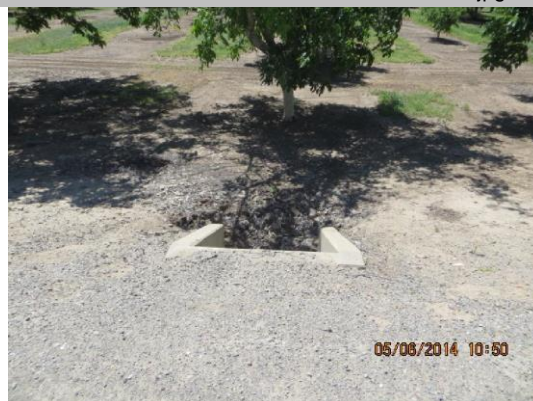
Photo 1 of 3 : UCIP\_FA\_2018\_36187\_65508.jpg

LM Start	11.15	Rating **	A/W	Issue No.	842
LM End	11.15	Issue Type +	Ma	Location *	
Category	Supplemental			GPS Latitude/Longitude	
				Start	End
Item	DWR UCIP LMA Responsibility			37.960322 °	37.960322 °
				-121.164400 °	-121.164400 °
DWR ID	23355				
Comment Code					
Inspector Comment					
FS_ID:36187 DS_ID:23355 EP_NO: N/A Repair Type: No Action Needed Crossing Status: Found UCIP Comments: FIELD_STRUCT_DESC: 30-inch steel drainage pipe through the levee, 6 feet below the crown. Concrete U-shaped headwall on both ends. Flap gate on the waterside (WS) end. Grouted inlet and outlet. [Additional Reference(s): DWR Levee Log, 1992. USACE San Joaquin O&M Manual 611.1, Volume F, (HLM 11.45) corrugated metal pipe listed]. FS Date: 5/6/2014

Pipe and headwall visible on LS toe.

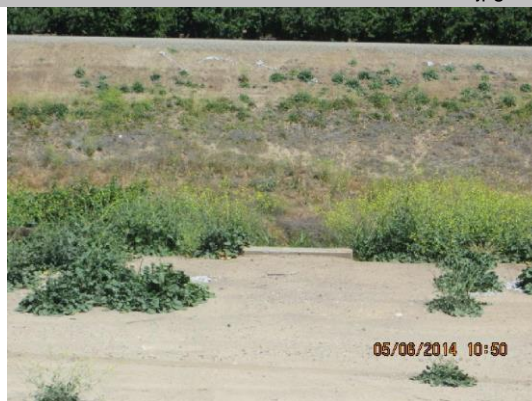
Photo 2 of 3 : UCIP\_FA\_2018\_36187\_65507.jpg

Pipe, flapgate, and headwall visible on WS shoulder.

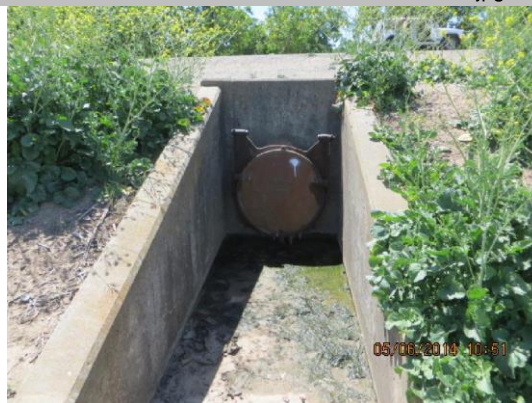
Photo 3 of 3 : UCIP\_FA\_2018\_36187\_65506.jpg

Pipe, flapgate, and headwall visible on WS shoulder.

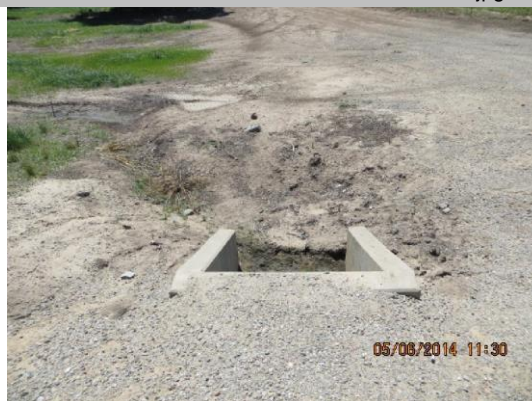
Photo 1 of 3 : UCIP\_FA\_2018\_36208\_65571.jpg

LM Start	11.92	Rating **	A/W	Issue No.	845	
LM End	11.92	Issue Type +	Ma	Location *		
Category	Supplemental			GPS Latitude/Longitude		
				Start	End	
Item	DWR UCIP LMA Responsibility			37.961429 °	37.961429 °	
				-121.178380 °	-121.178380 °	
DWR ID	23385					
Comment Code						
Inspector Comment						
FS_ID:36208						
DS_ID:23385						
EP_NO: N/A						
Repair Type: No Action Needed						
Crossing Status: Found						
UCIP Comments:						
FIELD_STRUCT_DESC: 30-inch corrugated metal drainage pipe through the levee, 5.5 feet below the crown. Concrete U-shaped headwall on both ends. Grouted inlet and outlet. Flap gate on the waterside (WS) end. [Additional Reference(s): DWR Levee Log, 1992. USACE San Joaquin O&M Manual 611.1, Volume F, (HLM 12.24)].						
FS Date: 5/6/2014

Concrete headwall on LS toe.

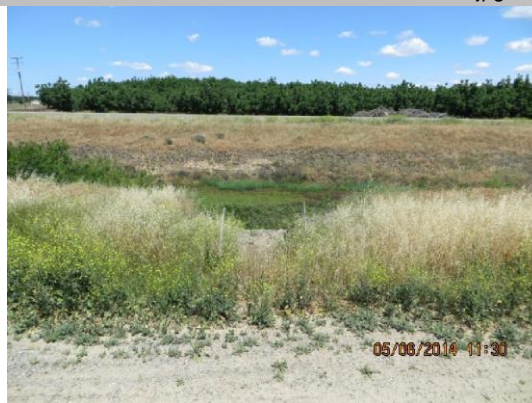
Photo 2 of 3 : UCIP\_FA\_2018\_36208\_65570.jpg

Pipe and concrete headwall on WS slope.

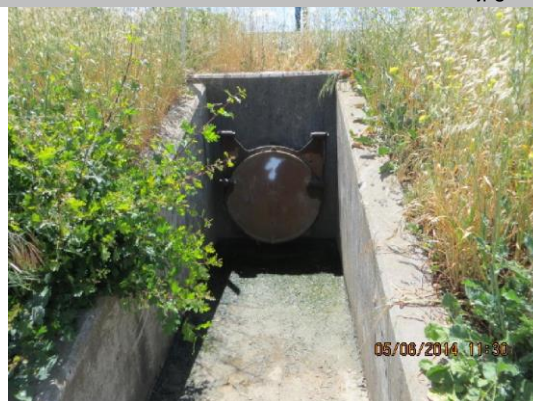
Photo 3 of 3 : UCIP\_FA\_2018\_36208\_65569.jpg

Pipe, headwall, and flapgate on WS slope.

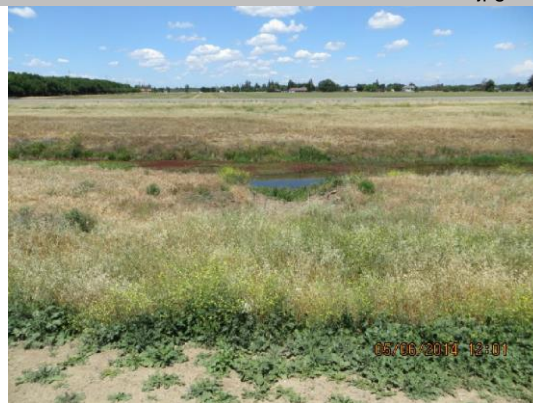
Photo 1 of 3 : UCIP\_FA\_2018\_36225\_65589.jpg

LM Start	12.26	Rating **	A/W	Issue No.	847
LM End	12.26	Issue Type +	Ma	Location *	
Category	Supplemental			GPS Latitude/Longitude	
				Start	End
Item	DWR UCIP LMA Responsibility			37.960568 °	37.960568 °
				-121.184451 °	-121.184451 °
DWR ID	23388				
Comment Code					
Inspector Comment					
FS_ID:36225					
DS_ID:23388					
EP_NO: N/A					
Repair Type: No Action Needed					
Crossing Status: Found					
UCIP Comments:					
FIELD_STRUCT_DESC: 30-inch corrugated metal drainage pipe through the levee, 9 feet below the crown. Concrete U-shaped headwall on both ends. Grouted inlet and outlet. Flap gate on the waterside (WS) end. [Additional Reference(s): DWR Levee Log, 1992. USACE San Joaquin O&M Manual 611.1, Volume F, (HLM 12.58)].					
FS Date: 5/6/2014

Grouted spillway on WS berm.

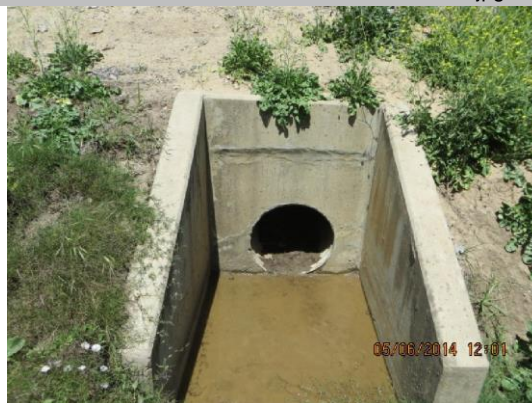
Photo 3 of 3 : UCIP\_FA\_2018\_36225\_65587.jpg

Concrete headwall on LS toe.

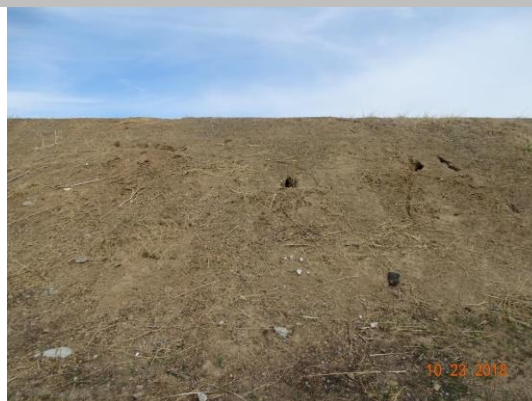
Photo 2 of 4 : FA\_2018\_NA0017\_160\_305\_20181024\_00461.jpg

LM Start	14.48	Rating **	U	Issue No.	305 (cont)	
LM End	14.48	Issue Type +	Ma	Location *	LS	
Category	Earthen Levee			GPS Latitude/Longitude		
				Start		End
Item	Animal Control			37.968788°	37.968788°	
				-121.220780°	-121.220780°	
DWR ID	DWR_NA0017_16_f_2018_305					
Comment Code						
A2 : Repair the levee slope damaged by livestock and prevent large animal access.						
Inspector Comment						
Many holes in the slope, should be repaired immediately.

View of more animal holes on the land side slope (October 2018).

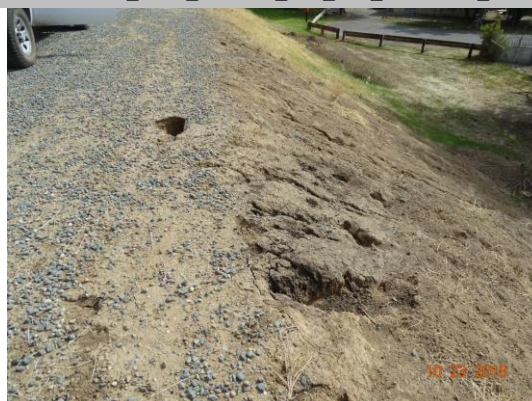
Photo 3 of 4 : FA\_2018\_NA0017\_160\_305\_20181024\_00462.jpg

View of animal holes at the top of the land side slope and the crown (October 2018).

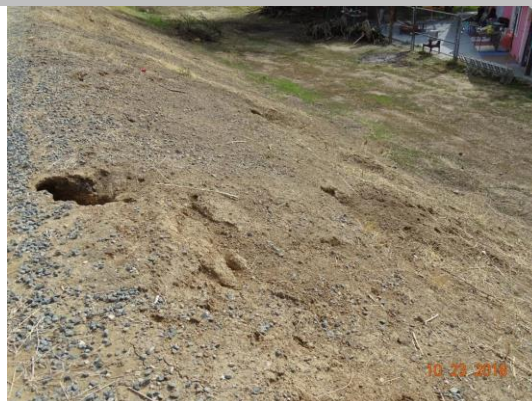
Photo 4 of 4 : FA\_2018\_NA0017\_160\_305\_20181024\_00466.jpg

View looking downslope at animal holes on the land side slope (October 2018).

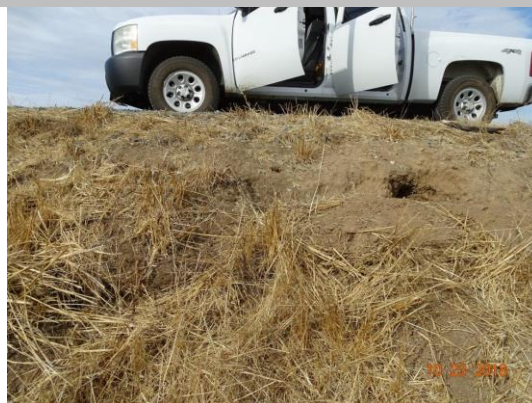
Photo 1 of 1 : FA\_2018\_NA0017\_160\_309\_20181024\_00468.jpg

LM Start	18.38	Rating **	M	Issue No.	309
LM End	18.38	Issue Type +	Ma	Location *	LS
Category	Earthen Levee			GPS Latitude/Longitude	
				Start	End
Item	Animal Control			37.992845 °	37.992845 °
				-121.283845 °	-121.283845 °
DWR ID	DWR_NA0017_16_f_2018_309				
Comment Code					
A1 : Exterminate rodents and backfill and compact or grout burrows.					
Inspector Comment

View of animal holes on the land side slope (October 2018).

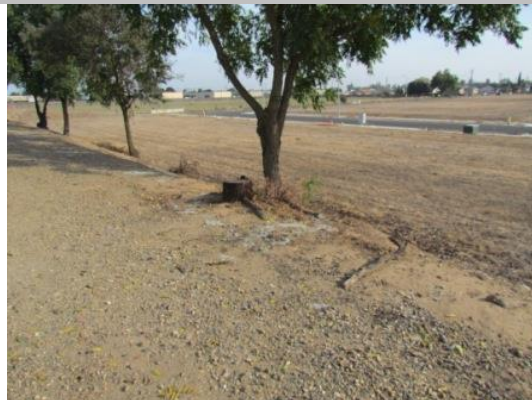
Photo 1 of 1 : FA\_2018\_NA0017\_160\_65\_20181003\_00091.jpg

LM Start	19.04	Rating **	N	Issue No.	65
LM End	19.04	Issue Type +	Ma	Location *	LS
Category	Earthen Levee			GPS Latitude/Longitude	
				Start	End
Item	Trim / Thin Trees			37.991617 °	37.991617 °
				-121.295628 °	-121.295628 °
DWR ID	DWR_NA0017_16_s_2012_65				
Comment Code					
T5 : Tree stumps.					
Inspector Comment					
This stump is at 18.94

A tree stump was found on the landside of the levee looking upstream.

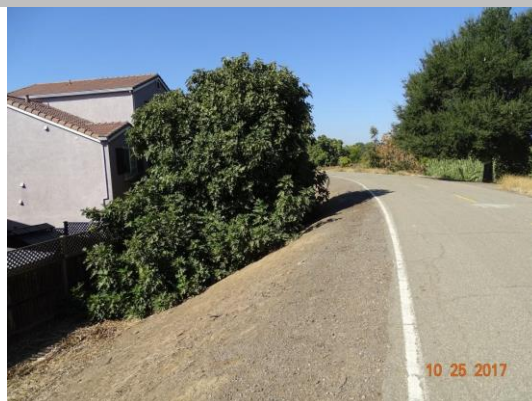
Photo 1 of 1 : FA\_2018\_NA0017\_160\_25\_20181003\_00021.jpg

LM Start	20.81	Rating **	M	Issue No.	25
LM End	20.81	Issue Type +	Ma	Location *	LS
Category	Earthen Levee			GPS Latitude/Longitude	
				Start	End
Item	Trim / Thin Trees			37.979925 °	37.979925 °
				-121.320179 °	-121.320179 °
DWR ID	DWR_NA0017_16_f_2017_25				
Comment Code					
T1 : Trim trees to at least five feet above ground level.					
Inspector Comment

View a tree that needs trimming on the landside slope of the levee. Fall 2017

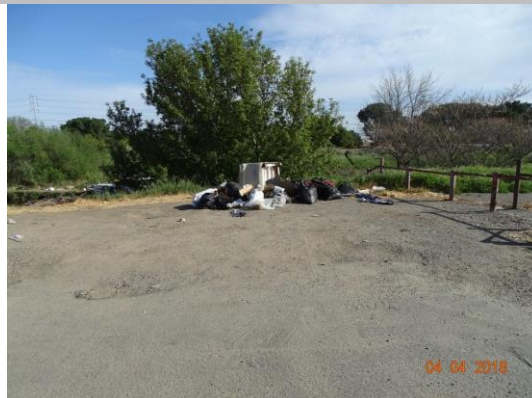
Photo 1 of 1 : FA\_2018\_NA0017\_160\_287\_20181003\_00212.jpg

LM Start	21.06	Rating **	A/W	Issue No.	287
LM End	21.06	Issue Type +	Ma	Location *	WS
Category	Earthen Levee			GPS Latitude/Longitude	
				Start	End
Item	Encroachments			37.980835 °	37.980835 °
				-121.324588 °	-121.324588 °
DWR ID	DWR_NA0017_16_s_2018_287				
Comment Code					
DE : Debris					
Inspector Comment

Debris waterside looking north.

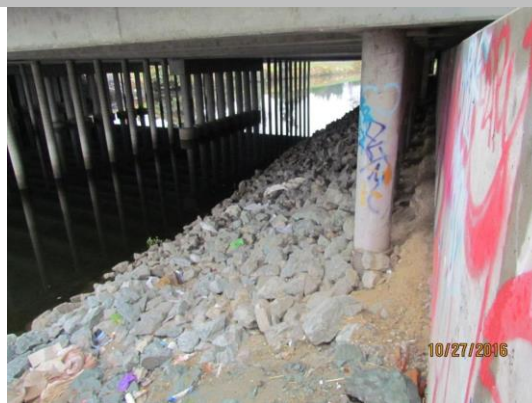
Photo 1 of 5 : FA\_2018\_NA0017\_160\_48\_20181003\_00064.jpg

LM Start	22.04	Rating **	A/W	Issue No.	48
LM End	22.04	Issue Type +	Ma	Location *	WS
Category	Earthen Levee			GPS Latitude/Longitude	
				Start	End
Item	Erosion / Bank Caving			37.978697 °	37.978697 °
				-121.341581 °	-121.341581 °
DWR ID	DWR_NA0017_16_s_2012_48				
Comment Code					
E2 : Schedule repair of erosion site prior to the next inspection.					
Inspector Comment					
Caltrans repaired the issue. (Permit # 18562) Another repair might be needed if it deteriorates.

View of the riprap on the waterside slope of the levee. Fall 2016

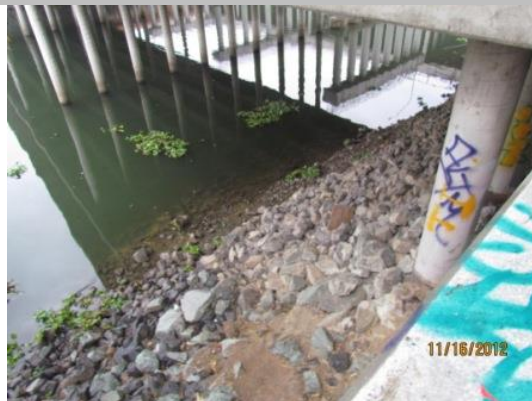
Photo 4 of 5 : FA\_2018\_NA0017\_160\_48\_20181003\_00067.jpg

Updated view of the erosion site repaired by Caltrans on the waterside slope of the levee looking upstream. Fall 2012

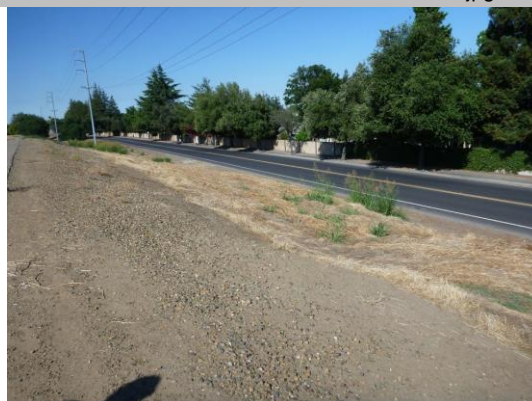
Photo 1 of 3 : LEVAL\_FA\_2018\_474\_2234.jpg

LM Start	22.19	Rating **	A/W	Issue No.	244
LM End	22.19	Issue Type +	Ma	Location *	
Category	Supplemental			GPS Latitude/Longitude	
				Start	End
Item	2017 Storm Damage			37.977185 °	37.977185 °
				-121.343687 °	-121.343687 °
DWR ID	DWR_NA0017_16_f_2017_244				
Comment Code					
Inspector Comment					
Levee Evaluation Comments					
Description:Erosion along the left bank of the waterside slope.					
Site ID No:474					
Site Designation:LMA-301					
Repair Type: Erosion					
Rating:Area of Concern					
Field Date:7/27/2017					
Notes: Lower priority because of the wide berm and erosion is only about 6 ft above water.

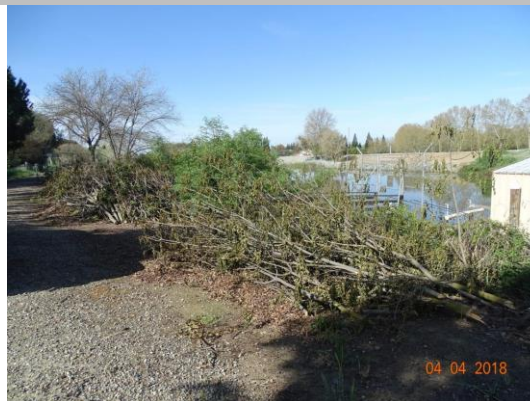
Photo 1 of 1 : FA\_2018\_NA0017\_160\_302\_20181003\_00216.jpg

LM Start	22.37	Rating **	M	Issue No.	302
LM End	22.37	Issue Type +	Ma	Location *	WS
Category	Earthen Levee			GPS Latitude/Longitude	
				Start	End
Item	Encroachments			37.975283 °	37.975283 °
				-121.345798 °	-121.345798 °
DWR ID	DWR_NA0017_16_s_2017_302				
Comment Code					
PR : Prunings					
Inspector Comment

Encroachment prunings crown looking east.

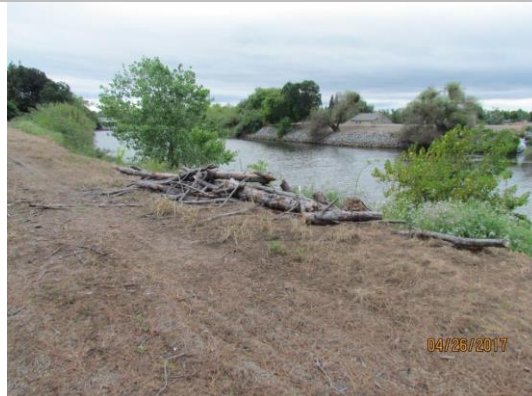
Photo 1 of 1 : FA\_2018\_NA0017\_160\_303\_20181003\_00217.jpg

LM Start	22.46	Rating **	A/W	Issue No.	303
LM End	22.46	Issue Type +	Ma	Location *	WS
Category	Earthen Levee			GPS Latitude/Longitude	
				Start	End
Item	Encroachments			37.974267°	37.974267°
				-121.346955°	-121.346955°
DWR ID	DWR_NA0017_16_s_2017_303				
Comment Code					
PR : Prunings					
Inspector Comment

View of prunings on the waterside of the levee.

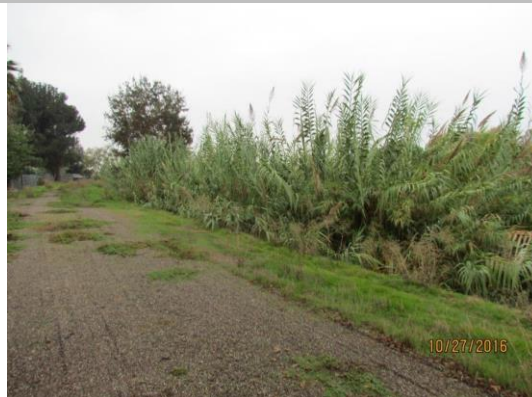
Photo 1 of 2 : FA\_2018\_NA0017\_160\_45\_20181003\_00057.jpg

LM Start	22.53	Rating **	U	Issue No.	45
LM End	22.53	Issue Type +	Ma	Location *	WS
Category	Earthen Levee			GPS Latitude/Longitude	
				Start	End
Item	Vegetation			37.973578°	37.973578°
				-121.347848°	-121.347848°
DWR ID	DWR_NA0017_16_f_2012_45				
Comment Code					
V2 : Remove the wild growth other than native grasses from the levee slopes.					
Inspector Comment					
Arundo on the waterside of the levee is completely blocking the visibility.

Updated picture of the arundo on the waterside slope of the levee. Fall 2016

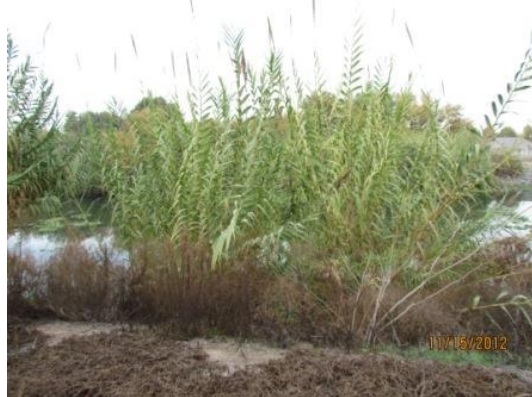
Photo 2 of 2 : FA\_2018\_NA0017\_160\_45\_20181003\_00058.jpg

LM Start	<b>22.53</b>	Rating **	U	Issue No.	<b>45 (cont)</b>
LM End	<b>22.53</b>	Issue Type +	Ma	Location *	WS

Arundo was found on the waterside slope of the levee looking upstream.

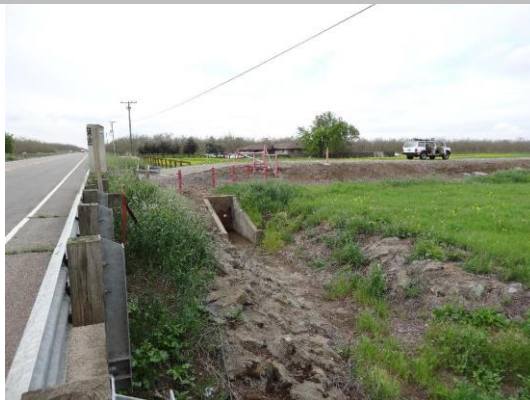
Photo 1 of 3 : UCIP\_FA\_2018\_33112\_59886.jpg

WS view: overview of pipe culvert and grouted riprap spillway.

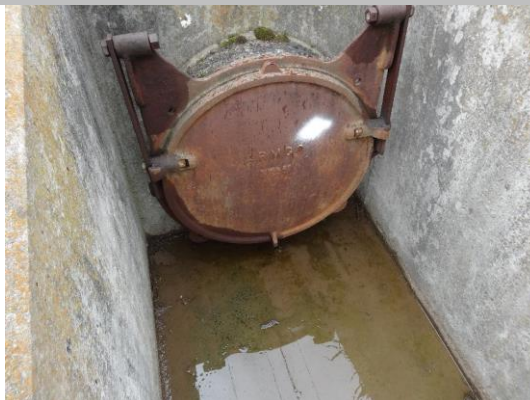
Photo 2 of 3 : UCIP\_FA\_2018\_33112\_59885.jpg

WS view: close view of CM pipe, flapgate, and concrete headwall.

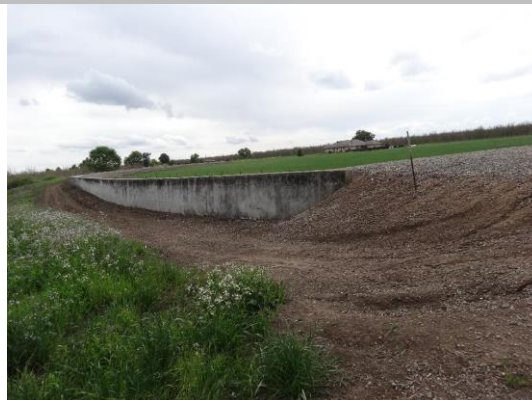
Photo 2 of 3 : UCIP\_FA\_2018\_33113\_59892.jpg

WS view: concrete flood wall along the levee on waterside.

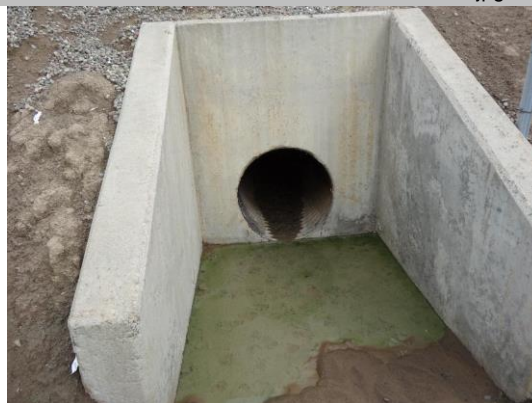
Photo 3 of 3 : UCIP\_FA\_2018\_33113\_59891.jpg

WS view: CM pipe, intake box, and concrete headwall on levee slope.

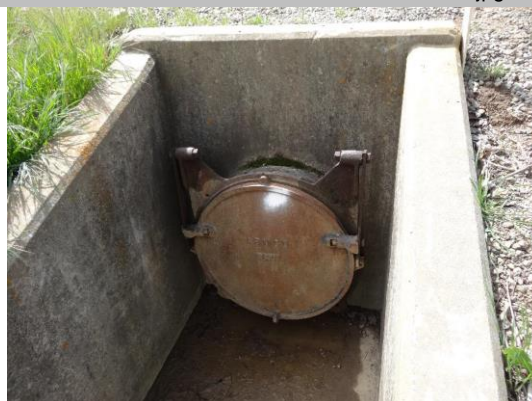
Photo 1 of 3 : UCIP\_FA\_2018\_33114\_59898.jpg

WS view: CM pipe, flapgate, and concrete headwall on levee slope.

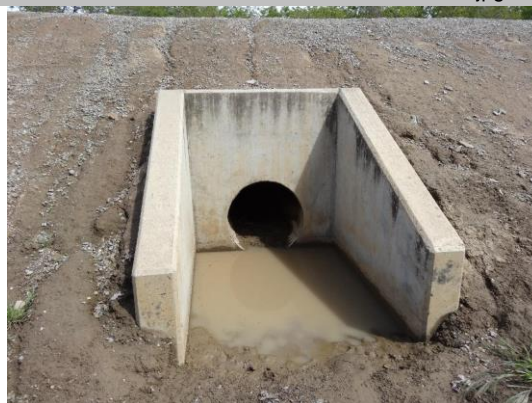
Photo 2 of 3 : UCIP\_FA\_2018\_33114\_59897.jpg

LS view: CM pipe, inlet box, and concrete headwall on levee slope.
