**Flood Control Project Maintenance
Levee Inspections**

Maintenance Issue Types Only, Levee Inspection Report By Mile - Fall 2019

San Joaquin County Flood Control and Water Conservation District

Waterway	Bank	Unit Miles	Inspection Start/End	Inspector
Unit No. 01 Littlejohn Creek	Left	2.59	11/14/2019 11/14/2019	Alberto De Leon

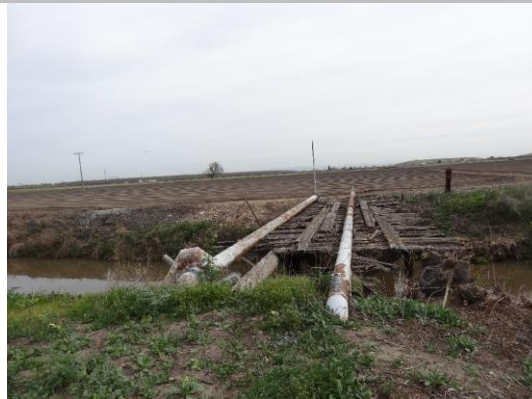
Photo 1 of 3 : UCIP_FA_2019_32744_59245.jpg

Comment Code					
Inspector Comment					
DS_ID:23992 FS_ID:32744 EP_NO: N/A Repair Type: No Action Needed Crossing Status: Found UCIP Comments: One 4-inch pvc pipe on the waterside levee slope. It is not clear whether the pvc pipe goes through the levee. One air vent on waterside and another across the channel. Water filter plant on landside. Not found : 24-inch CMP through levee and with flap gate. On landside a vertical pump on wooden structure; walkway to the pump; service pole and switch box. Pump is connected to 8-inch steel pipe for about 100 ft. 24-inch CMP continues through the levee. FIELD_STRUCT_DESC: 8-inch steel storm drainage pipe through the levee, 2 feet below the crown. Pipe goes over the top of the channel on a wood structure. One air vent on the waterside (WS) and another across the channel. Water filter plant on the landside (LS). [Additional Reference(s): DWR Levee Log, 1977, listed as a 14-inch pipe. USACE San Joaquin O&M Manual 613C, Volume 15, May 1963, (Station 131+25 ""S""), listed as a 24-inch corrugated metal pipe (CMP) with a flap gate]. FS Date: 3/25/2014

WS view: two steel pipes through the levee and over Little John's Creek on wooden structure.

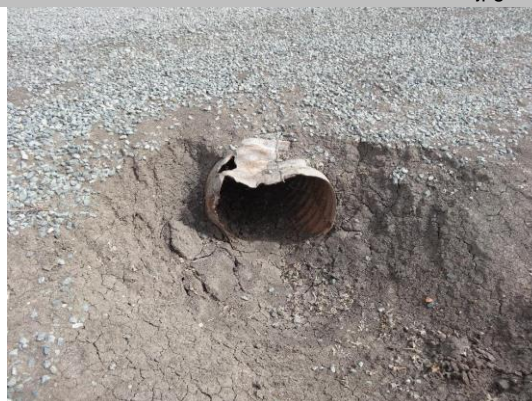
Photo 2 of 3 : UCIP_FA_2019_53494_59247.jpg

Comment Code						
Inspector Comment						
DS_ID:17973 FS_ID:53494 EP_NO: N/A Repair Type: Urgent Crossing Status: Found UCIP Comments: 11/02/2018 Inlet deformed. Outlet missing a slide gate. The LMA states that a new slide gate will be installed in about two weeks. Inlet and outlet have dirt and vegetation issues. Crossing remains "Urgent" until a new slide gate is installed. Contact the LMA to see if they have photographic evidence that a new slide gate was put in. (A. McDonald - DWR UCIP)10/18/2018 Inlet deformed. Outlet missing a slide gate. This means that the pipe cannot be closed during high water. I have escalated this crossing from "No Action Needed" to "Urgent" due to the straight through pipe which could cause flooding during high water. There is a hole in the inlet, due to the deformity. It was most likely ran over by heavy equipment. I do not see enough evidence for an internal pipe inspection. (A. McDonald - DWR UCIP)03/25/2014 May need cleaning of mud in inlet pipe. (W. Wylie - DWR UCIP) FIELD_STRUCT_DESC: 24-inch corrugated metal drainage culvert through the levee, 4.2 feet below the crown. Slide gate on the waterside (WS) end, not found on 10/18/2018. [Additional Reference(s): DWR Levee Log, 1977. USACE San Joaquin O&M Manual 613C, Volume 15, May 1963, (Station 98+65)]. FS Date: 11/2/2018 2:54:00 PM

LS view: deformed CMP inlet on a drainage ditch.

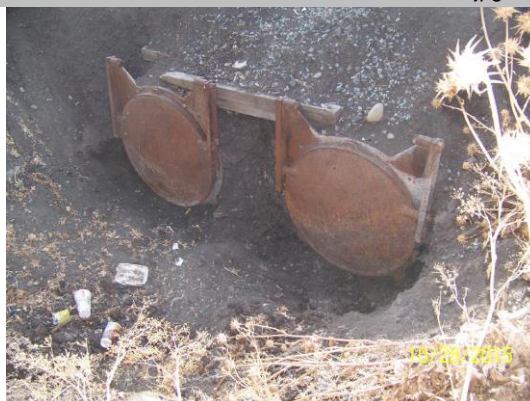
Photo 1 of 3 : UCIP_FA_2019_53461_74752.jpg

Comment Code						
Inspector Comment						
DS_ID:17972						
FS_ID:53461						
EP_NO: N/A						
Repair Type: No Action Needed						
Crossing Status: Found						
UCIP Comments: 11/02/2018 Inlet and outlet cleared of dirt by the LMA. Crossing has been downgraded to "No Action Needed." (A. McDonald - DWR UCIP)03/25/2014 LS vegetation debris and mud on the inlet ditch and inside the pipe. (P. Amatya - DWR UCIP)						
FIELD_STRUCT_DESC: 1 of 2: 36-inch corrugated metal drainage pipe through the levee, 6.6 feet below the crown. Flap gate on the waterside (WS) end. [Additional Reference(s): DWR Levee Log, 1977. USACE San Joaquin O&M Manual 613C, Volume 15, May 1963 (Station 94+40)].						
FS Date: 11/2/2018 3:23:00 PM

WS: Debris blocking flap gate has been cleared per FPIIB Inspector email 11/16/2015

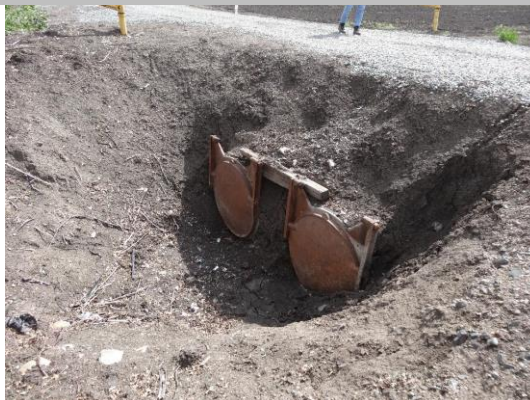
Photo 2 of 3 : UCIP_FA_2019_53461_59185.jpg

WS view: CMP drain pipes with flap gates on ditch.

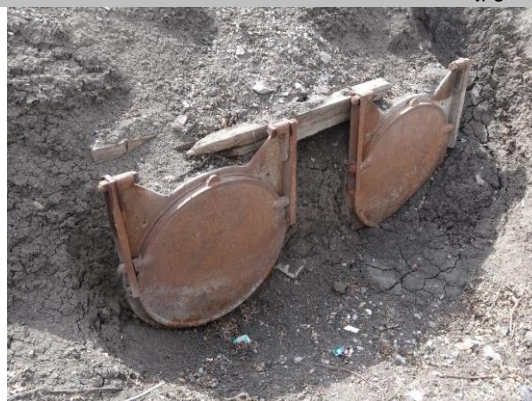
Photo 3 of 3 : UCIP_FA_2019_53461_59184.jpg

Item	DRAFT DWR UCIP LMA Responsibility			37.878502 °		37.878502 °
				-121.242377 °		-121.242377 °
DWR ID	17972					
Comment Code						
Inspector Comment						
DS_ID:17972						
FS_ID:53461						
EP_NO: N/A						
Repair Type: No Action Needed						
Crossing Status: Found						
UCIP Comments: 11/02/2018 Inlet and outlet cleared of dirt by the LMA. Crossing has been downgraded to "No Action Needed." (A. McDonald - DWR UCIP)03/25/2014 LS vegetation debris and mud on the inlet ditch and inside the pipe. (P. Amatya - DWR UCIP)						
FIELD_STRUCT_DESC: 1 of 2: 36-inch corrugated metal drainage pipe through the levee, 6.6 feet below the crown. Flap gate on the waterside (WS) end. [Additional Reference(s): DWR Levee Log, 1977. USACE San Joaquin O&M Manual 613C, Volume 15, May 1963 (Station 94+40)].						
FS Date: 11/2/2018 3:23:00 PM

WS view: closer view of CMP drain pipes with flap gates on ditch. Right flap gate was blocked by soil/mud.

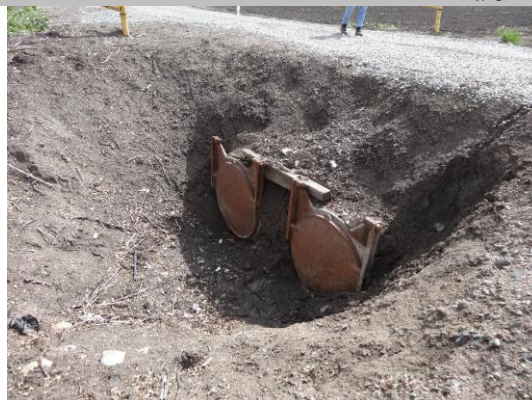
Photo 1 of 3 : UCIP_FA_2019_53130_59191.jpg

Comment Code						
Inspector Comment						
DS_ID:23995						
FS_ID:53130						
EP_NO: N/A						
Repair Type: No Action Needed						
Crossing Status: Found						
UCIP Comments: 11/02/2018 Inlet and outlet covered in dirt. Inlet and outlet cleared of dirt by the LMA. (A. McDonald - DWR UCIP)03/25/2014 Needs cleaning and clearing of the culvert. (P. Amatya - DWR UCIP)						
FIELD_STRUCT_DESC: 2 of 2: 36-inch corrugated metal drainage pipe through the levee, 6.6 feet below the crown. Flap gate on the waterside (WS) end. [Additional Reference(s): DWR Levee Log, 1977. USACE San Joaquin O&M Manual 613C, Volume 15, May 1963 (Station 94+40)].						
FS Date: 11/2/2018 3:30:16 PM

WS view: CMP drain pipes with flap gates on ditch.

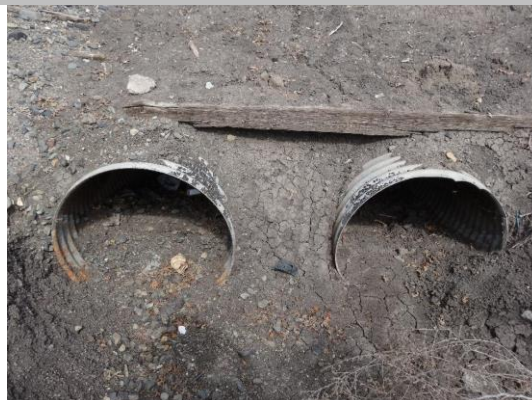
Photo 3 of 3 : UCIP_FA_2019_53130_59189.jpg

Item	DRAFT DWR UCIP LMA Responsibility			37.878494 °	37.878494 °	
				-121.242392 °	-121.242392 °	
DWR ID	23995					
Comment Code						
Inspector Comment						
DS_ID:23995 FS_ID:53130 EP_NO: N/A Repair Type: No Action Needed Crossing Status: Found UCIP Comments: 11/02/2018 Inlet and outlet covered in dirt. Inlet and outlet cleared of dirt by the LMA. (A. McDonald - DWR UCIP)03/25/2014 Needs cleaning and clearing of the culvert. (P. Amatya - DWR UCIP) FIELD_STRUCT_DESC: 2 of 2: 36-inch corrugated metal drainage pipe through the levee, 6.6 feet below the crown. Flap gate on the waterside (WS) end. [Additional Reference(s): DWR Levee Log, 1977. USACE San Joaquin O&M Manual 613C, Volume 15, May 1963 (Station 94+40)]. FS Date: 11/2/2018 3:30:16 PM

LS view: CMP inlet pipes on levee slope. Debris and mud on inlet ditch and inside the pipe.

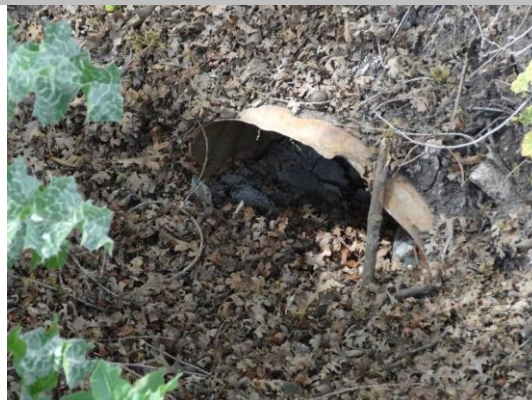
Photo 2 of 3 : UCIP_FA_2019_53459_59250.jpg

Comment Code						
Inspector Comment						
DS_ID:23985 FS_ID:53459 EP_NO: N/A Repair Type: No Action Needed Crossing Status: Found UCIP Comments: 11/02/2018 Inlet and outlet cleared of dirt and vegetation by the LMA. Crossing has been downgraded to "No Action Needed." (A. McDonald - DWR UCIP)03/25/2014 Debris and mud on inlet ditch and inside pipe. Needs cleaning and clearing the culvert. (P. Amatya - DWR UCIP) FIELD_STRUCT_DESC: 30-inch corrugated metal drainage pipe through the levee, 11 feet below the crown. Flap gate on the waterside (WS). [Additional Reference(s): USACE San Joaquin O&M Manual 613C, Volume 15, May 1963, (Station 83+00)]. FS Date: 11/2/2018 2:31:00 PM

LS view: CMP inlet pipe on levee slope. Vegetation debris and mud on inlet ditch.

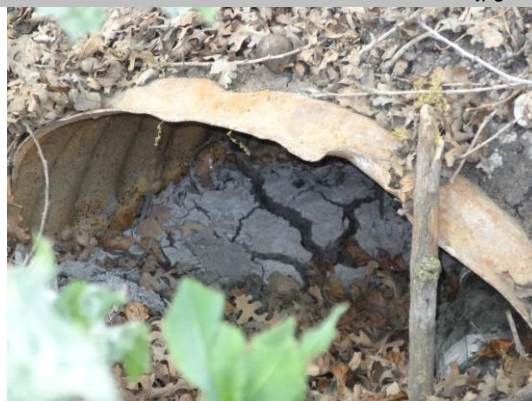
Photo 3 of 3 : UCIP_FA_2019_53459_59249.jpg

Item	DRAFT DWR UCIP LMA Responsibility			37.877566 °		37.877566 °
				-121.246391 °		-121.246391 °
DWR ID	23985					
Comment Code						
Inspector Comment						
DS_ID:23985						
FS_ID:53459						
EP_NO: N/A						
Repair Type: No Action Needed						
Crossing Status: Found						
UCIP Comments: 11/02/2018 Inlet and outlet cleared of dirt and vegetation by the LMA. Crossing has been downgraded to "No Action Needed." (A. McDonald - DWR UCIP)03/25/2014 Debris and mud on inlet ditch and inside pipe. Needs cleaning and clearing the culvert. (P. Amatya - DWR UCIP)						
FIELD_STRUCT_DESC: 30-inch corrugated metal drainage pipe through the levee, 11 feet below the crown. Flap gate on the waterside (WS). [Additional Reference(s): USACE San Joaquin O&M Manual 613C, Volume 15, May 1963, (Station 83+00)].						
FS Date: 11/2/2018 2:31:00 PM

LS view: inside view of CM inlet pipe. Needs cleaning and clearing the culvert.

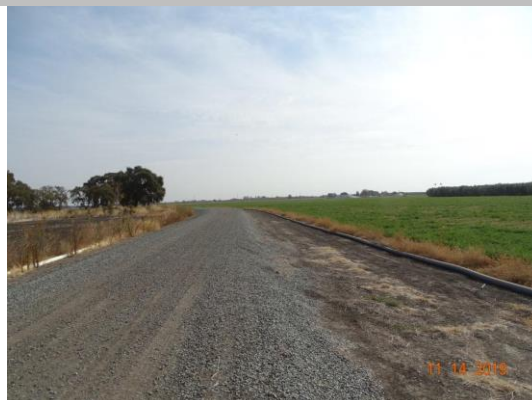
Photo 1 of 1 : FA_2019_NA0017_148_15_20191117_00038.jpg

LM Start	1.13	Rating **	A	Issue No.	15	
LM End	1.13	Issue Type +	Ma	Location *	LS	
Category	Earthen Levee			GPS Latitude/Longitude		
				Start		End
Item	Vegetation			37.878521 °		37.878521 °
				-121.247808 °		-121.247808 °
DWR ID	DWR_NA0017_01_f_2019_15					
Comment Code						
V1 : Control annual grass and weeds on the levee slopes and easements.						
Inspector Comment

Typical view of vegetation on landside slope. Fall 2019

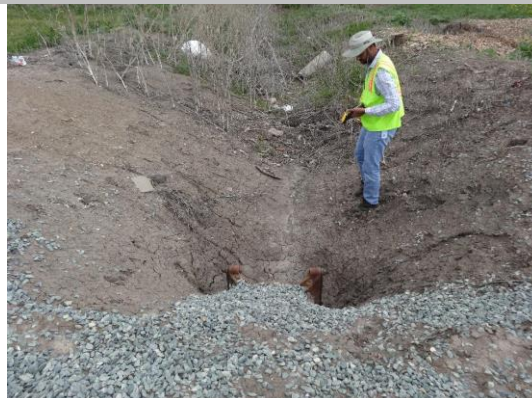
Photo 1 of 3 : UCIP_FA_2019_53458_59254.jpg

Comment Code						
Inspector Comment						
DS_ID:17970 FS_ID:53458 EP_NO: N/A Repair Type: Non-Urgent Crossing Status: Found UCIP Comments: 11/02/2018 Inlet still deformed. Inlet and outlet cleared of dirt and vegetation by the LMA. Crossing continues to be rated "Non-Urgent." (A. McDonald - DWR UCIP)03/25/2014 Needs cleaning and clearing the culvert. (P. Amatya - DWR UCIP) FIELD_STRUCT_DESC: 24-inch corrugated metal drainage pipe through the levee, 4.1 feet below the crown. Flap gate on the waterside (WS) end. [Additional Reference(s): DWR Levee Log, 1977. USACE San Joaquin O&M Manual 613C, Volume 15, May 1963, (Station 76+60)]. FS Date: 11/2/2018 2:22:00 PM

WS view: CM drain pipe with flap gate on levee slope. Dirt spillway to the creek.

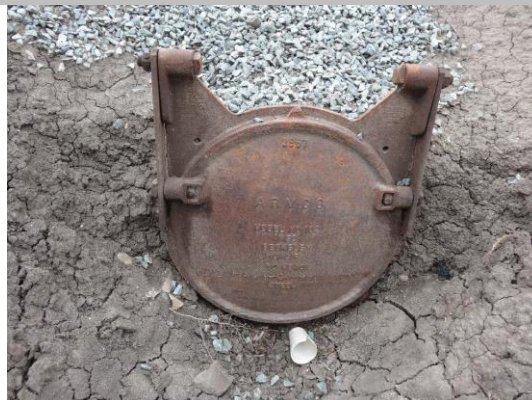
Photo 2 of 3 : UCIP_FA_2019_53458_59253.jpg

WS view: closer view of CM drain pipe with flap gate on levee slope.

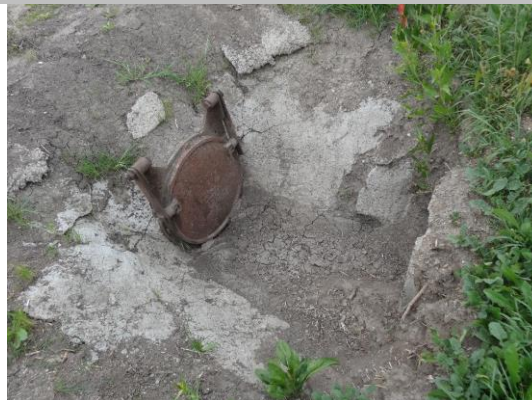
Photo 2 of 3 : UCIP_FA_2019_53462_59120.jpg

Item	DRAFT DWR UCIP LMA Responsibility			37.888080 °	37.888080 °	
				-121.266631 °	-121.266631 °	
DWR ID	17966					
Comment Code						
Inspector Comment						
DS_ID:17966 FS_ID:53462 EP_NO: N/A Repair Type: No Action Needed Crossing Status: Found UCIP Comments: 11/02/2018 Inlet uncovered from the dirt by the LMA. Some vegetation at the flap gate. Crossing continues to be rated "No Action Needed." (A. McDonald - DWR UCIP)03/25/2014 Grouted riprap outlet box and concrete outfall pipe on waterside. Pipe not visible on landside. (P. Amatya - DWR UCIP) FIELD_STRUCT_DESC: 24-inch corrugated metal drainage pipe through the levee, 5 feet below the crown. Flap gate on the waterside (WS) end. Grouted riprap outlet box and concrete outfall pipe on the WS. [Additional Reference(s): DWR Levee Log, 1977. USACE San Joaquin O&M Manual 613C, Volume 15, May 1963, (Station 4+00)]. FS Date: 11/2/2018 3:43:00 PM

WS view: outlet pipe with flap gate. Grouted riprap on spillway.

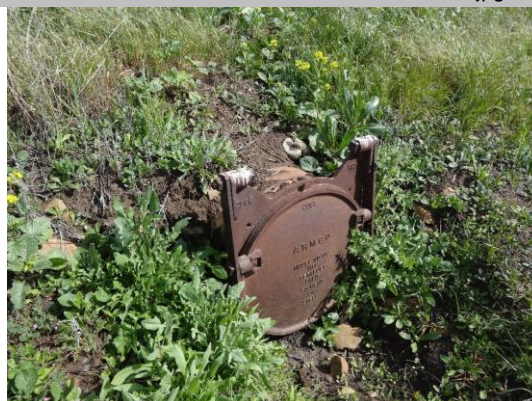
Photo 1 of 3 : UCIP_FA_2019_53457_59931.jpg

LM Start	0.50	Rating **	A/W	Issue No.	21	
LM End	0.50	Issue Type +	Ma	Location *		
Category	Supplemental			GPS Latitude/Longitude		
				Start		End
Item	DRAFT DWR UCIP LMA Responsibility			37.875178 °		37.875178 °
				-121.228514 °		-121.228514 °
DWR ID	17986					
Comment Code						
Inspector Comment						
DS_ID:17986 FS_ID:53457 EP_NO: N/A Repair Type: No Action Needed Crossing Status: Found UCIP Comments: 11/02/2018 Inlet cleared of dirt and vegetation by the LMA. Crossing continues to be rated "No Action Needed." (A. McDonald - DWR UCIP)04/02/2014 May need cleaning. (P. Amatya - DWR UCIP) FIELD_STRUCT_DESC: 24-inch corrugated metal drainage pipe through the levee, 5 feet below the crown. Flap gate on the waterside (WS) end. [Additional Reference(s): DWR Levee Log, 1977. USACE San Joaquin O&M Manual 613C, Volume 15, May 1963, (Station 148+18N)]. FS Date: 11/2/2018 2:16:00 PM

WS view: CM drain pipe with flap gate on creek bank.

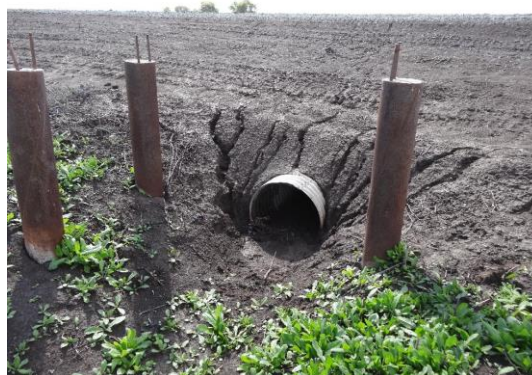
Photo 2 of 3 : UCIP_FA_2019_53457_59930.jpg

LS view: CM inlet pipe on levee slope. Mud on inlet ditch and pipe.

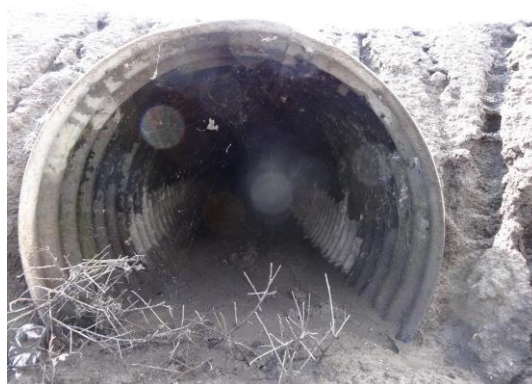
Photo 3 of 3 : UCIP_FA_2019_53457_59929.jpg

Comment Code						
Inspector Comment						
DS_ID:17986 FS_ID:53457 EP_NO: N/A Repair Type: No Action Needed Crossing Status: Found UCIP Comments: 11/02/2018 Inlet cleared of dirt and vegetation by the LMA. Crossing continues to be rated "No Action Needed." (A. McDonald - DWR UCIP)04/02/2014 May need cleaning. (P. Amatya - DWR UCIP) FIELD_STRUCT_DESC: 24-inch corrugated metal drainage pipe through the levee, 5 feet below the crown. Flap gate on the waterside (WS) end. [Additional Reference(s): DWR Levee Log, 1977. USACE San Joaquin O&M Manual 613C, Volume 15, May 1963, (Station 148+18N)]. FS Date: 11/2/2018 2:16:00 PM

LS view: closer view of CM inlet pipe. Mud on inlet ditch and pipe. May need cleaning.

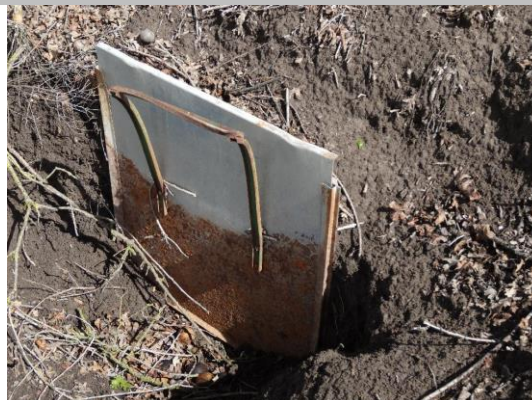
Photo 2 of 3 : UCIP_FA_2019_53453_59936.jpg

Comment Code						
Inspector Comment						
DS_ID:17983 FS_ID:53453 EP_NO: N/A Repair Type: No Action Needed Crossing Status: Found UCIP Comments: 11/02/2018 Inlet and outlet cleared of dirt and vegetation by the LMA. Crossing has been downgraded to "No Action Needed." (A. McDonald - DWR UCIP)04/02/2014 Needs cleaning and clearing the culvert. (P. Amatya - DWR UCIP) FIELD_STRUCT_DESC: 24-inch corrugated metal drainage pipe through the levee, 6.4 feet below the crown. Flap gate on the waterside (WS) end. [Additional Reference(s): DWR Levee Log, 1977. USACE San Joaquin O&M Manual 613C, Volume 15, May 1963, (Station 114+50)]. FS Date: 11/2/2018 11:37:00 AM

WS view: closer view of plate gate on the CM pipe end.

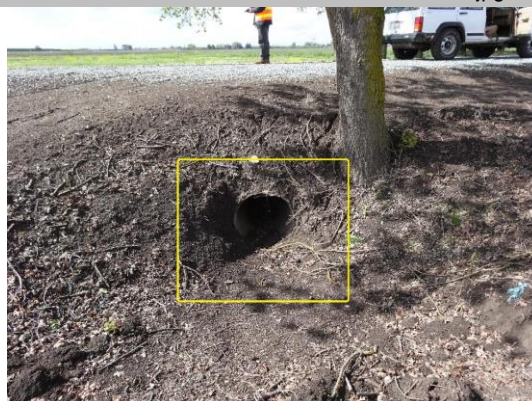
Photo 3 of 3 : UCIP_FA_2019_53453_59938.jpg

Comment Code						
Inspector Comment						
DS_ID:17983 FS_ID:53453 EP_NO: N/A Repair Type: No Action Needed Crossing Status: Found UCIP Comments: 11/02/2018 Inlet and outlet cleared of dirt and vegetation by the LMA. Crossing has been downgraded to "No Action Needed." (A. McDonald - DWR UCIP)04/02/2014 Needs cleaning and clearing the culvert. (P. Amatya - DWR UCIP) FIELD_STRUCT_DESC: 24-inch corrugated metal drainage pipe through the levee, 6.4 feet below the crown. Flap gate on the waterside (WS) end. [Additional Reference(s): DWR Levee Log, 1977. USACE San Joaquin O&M Manual 613C, Volume 15, May 1963, (Station 114+50)]. FS Date: 11/2/2018 11:37:00 AM

LS view: CM inlet pipe on levee slope.

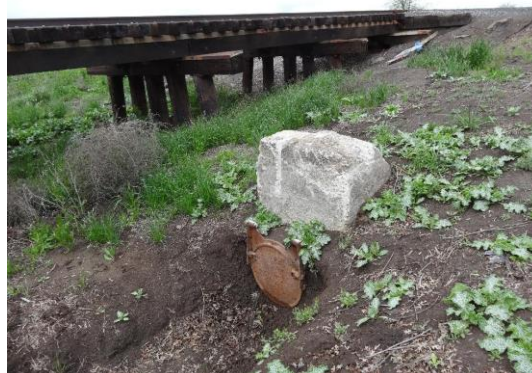
Photo 1 of 3 : UCIP_FA_2019_53455_59947.jpg

Comment Code						
Inspector Comment						
DS_ID:23984						
FS_ID:53455						
EP_NO: N/A						
Repair Type: No Action Needed						
Crossing Status: Found						
UCIP Comments: 11/02/2018 Inlet and outlet cleared of dirt and vegetation by the LMA. Crossing continues to be rated "No Action Needed." (A. McDonald - DWR UCIP)04/02/2014 May need cleaning. (P. Amatya - DWR UCIP)						
FIELD_STRUCT_DESC: 24-inch corrugated metal drainage pipe with flap gate through the levee, at an unknown depth. [Additional						
Reference(s): USACE San Joaquin O&M Manual 613C, Volume 15, May 1963, (Station 93+00)].						
FS Date: 11/2/2018 1:46:00 PM

WS view: CM drain pipe with flap gate on levee slope.

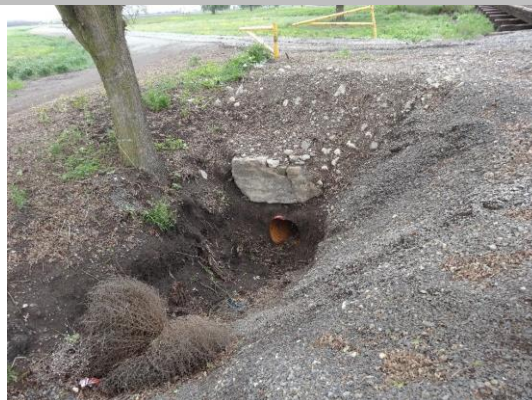
Photo 2 of 3 : UCIP_FA_2019_53455_59946.jpg

LS view: CM drain pipe on drainage ditch. Mud and vegetation debris on the pipe.

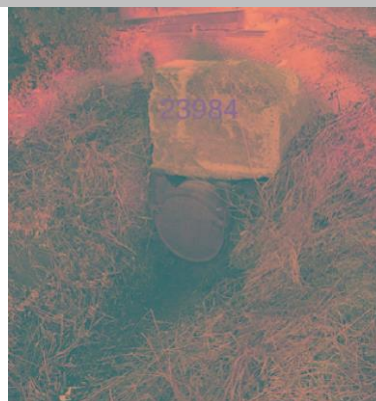
Photo 3 of 3 : UCIP_FA_2019_53455_78394.jpg

Comment Code						
Inspector Comment						
DS_ID:23984						
FS_ID:53455						
EP_NO: N/A						
Repair Type: No Action Needed						
Crossing Status: Found						
UCIP Comments: 11/02/2018 Inlet and outlet cleared of dirt and vegetation by the LMA. Crossing continues to be rated "No Action Needed." (A. McDonald - DWR UCIP)04/02/2014 May need cleaning. (P. Amatya - DWR UCIP)						
FIELD_STRUCT_DESC: 24-inch corrugated metal drainage pipe with flap gate through the levee, at an unknown depth. [Additional Reference(s): USACE San Joaquin O&M Manual 613C, Volume 15, May 1963, (Station 93+00)].						
FS Date: 11/2/2018 1:46:00 PM

Outlet cleared of dirt and vegetation by the LMA.

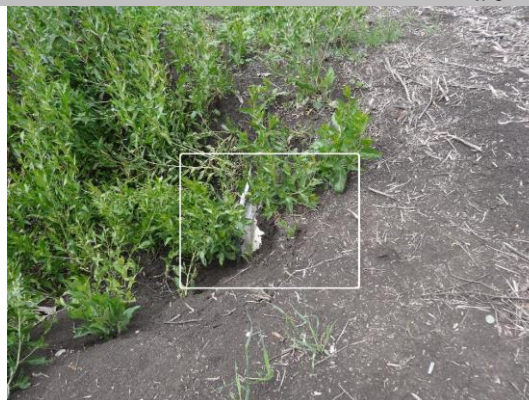
Photo 1 of 3 : UCIP_FA_2019_53452_59952.jpg

Comment Code					
Inspector Comment					
DS_ID:23998 FS_ID:53452 EP_NO: N/A Repair Type: No Action Needed Crossing Status: Found UCIP Comments: 11/02/2018 Inlet and outlet cleared of dirt and vegetation by the LMA. This crossing continues to be rated "No Action Needed." (A. McDonald - DWR UCIP)04/02/2014 Galvanized iron plate slide gate on waterside. It is not not a old pipe. The plate gate looks new. (P. Amatya - DWR UCIP) FIELD_STRUCT_DESC: 16-inch high-density polyethylene drainage pipe through the levee, 7.7 feet below the crown. Galvanized iron plate gate on the waterside (WS) end. [Additional Reference(s): USACE San Joaquin O&M Manual 613C, Volume 15, May 1963, (Station 91+80) 12-inch steel pipe listed]. FS Date: 11/2/2018 11:05:00 AM

WS view: HDPE drain pipe on levee slope.

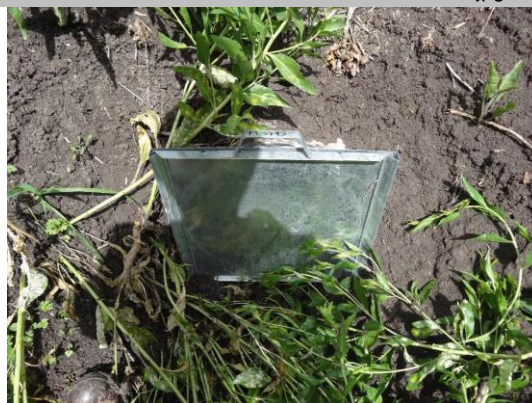
Photo 2 of 3 : UCIP_FA_2019_53452_59951.jpg

Comment Code						
Inspector Comment						
DS_ID:23998 FS_ID:53452 EP_NO: N/A Repair Type: No Action Needed Crossing Status: Found UCIP Comments: 11/02/2018 Inlet and outlet cleared of dirt and vegetation by the LMA. This crossing continues to be rated "No Action Needed." (A. McDonald - DWR UCIP)04/02/2014 Galvanized iron plate slide gate on waterside. It is not not a old pipe. The plate gate looks new. (P. Amatya - DWR UCIP) FIELD_STRUCT_DESC: 16-inch high-density polyethylene drainage pipe through the levee, 7.7 feet below the crown. Galvanized iron plate gate on the waterside (WS) end. [Additional Reference(s): USACE San Joaquin O&M Manual 613C, Volume 15, May 1963, (Station 91+80) 12-inch steel pipe listed]. FS Date: 11/2/2018 11:05:00 AM

WS view: closer view of galvanized iron plate slide gate on HDPE pipe end.

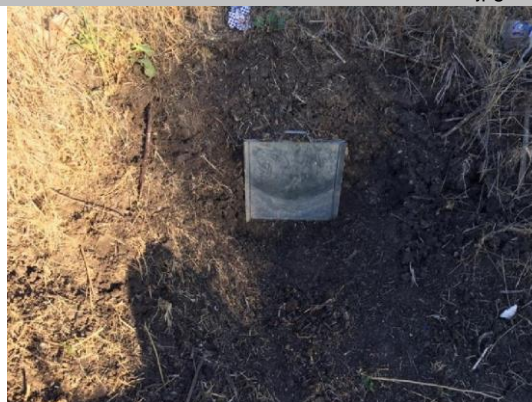
Photo 3 of 3 : UCIP_FA_2019_53452_78388.jpg

Outlet cleared of dirt and vegetation by the LMA.

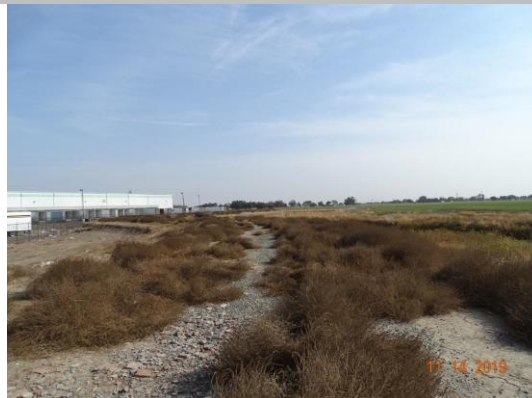
Photo 1 of 1 : FA_2019_NA0017_149_15_20191117_00033.jpg

LM Start	2.92	Rating **	U	Issue No.	15
LM End	3.18	Issue Type +	Ma	Location *	LS
Category	Earthen Levee			GPS Latitude/Longitude	
				Start	End
Item	Vegetation			37.888367°	37.888674°
				-121.263348°	-121.267802°
DWR ID	DWR_NA0017_02_f_2018_15				
Comment Code					
V2 : Remove the wild growth other than native grasses from the levee slopes.					
Inspector Comment					
Tumble weeds on WS, crown and LS should be removed. Add Gravel and spray to prevent veg growth.

View of tumbleweeds on waterside, landside and crown of levee. Fall 2019

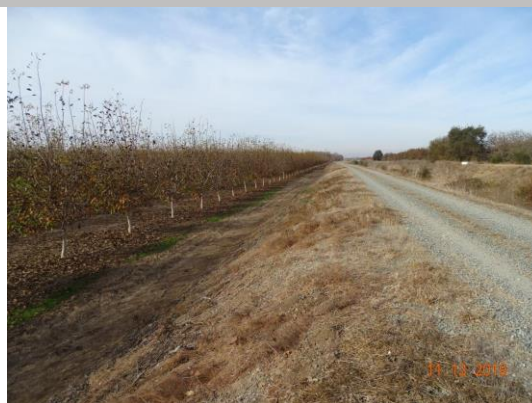
Photo 1 of 1 : FA_2019_NA0017_150_2_20191117_00004.jpg

LM Start	0.23	Rating **	A	Issue No.	2
LM End	0.46	Issue Type +	Ma	Location *	LS
Category	Earthen Levee			GPS Latitude/Longitude	
				Start	End
Item	Vegetation			37.979229°	37.979315°
				-121.094662°	-121.090477°
DWR ID	DWR_NA0017_06_f_2019_2				
Comment Code					
V1 : Control annual grass and weeds on the levee slopes and easements.					
Inspector Comment					
The annual vegetation in this section is well maintained, Fall 2019.

Typical view of vegetation on the landside slope. Fall 2019

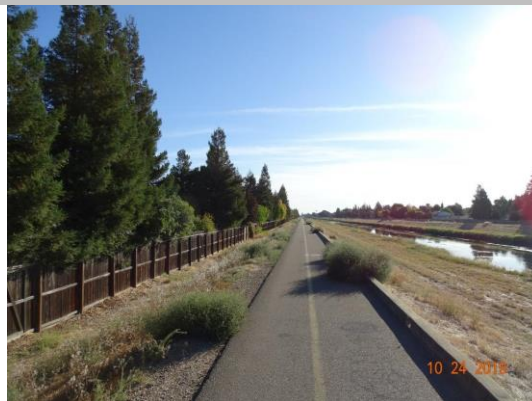
Photo 1 of 1 : FA_2019_NA0017_151_155_20191117_00341.jpg

LM Start	0.73	Rating **	M	Issue No.	155
LM End	0.73	Issue Type +	Ma	Location *	CR
Category	Earthen Levee			GPS Latitude/Longitude	
				Start	End
Item	Vegetation			38.043437 °	38.043437 °
				-121.360209 °	-121.360209 °
DWR ID	DWR_NA0017_07_f_2019_155				
Comment Code					
V2 : Remove the wild growth other than native grasses from the levee slopes.					
Inspector Comment					
Tumble weeds on levee crown need to be removed.

View of tumble weeds on crown surface. Fall 2019

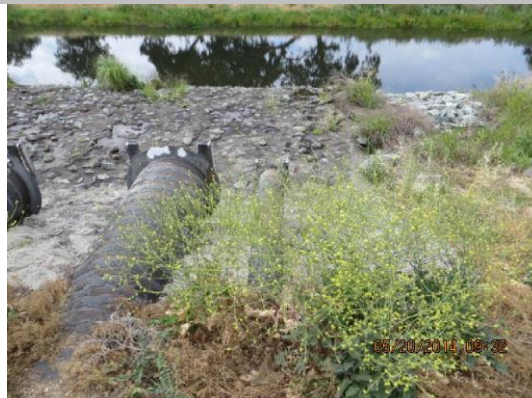
Photo 1 of 2 : UCIP_FA_2019_38092_69303.jpg

Pipe and flapgate visible on WS slope.

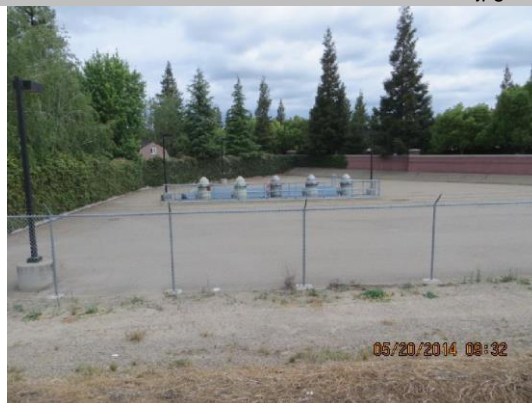
Photo 2 of 2 : UCIP_FA_2019_38092_69302.jpg

Pump over sump off LS toe.

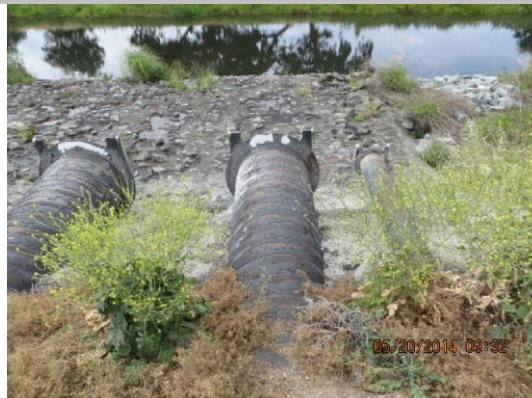
Photo 1 of 2 : UCIP_FA_2019_38093_69305.jpg

Pipe and flapgate visible on WS slope.

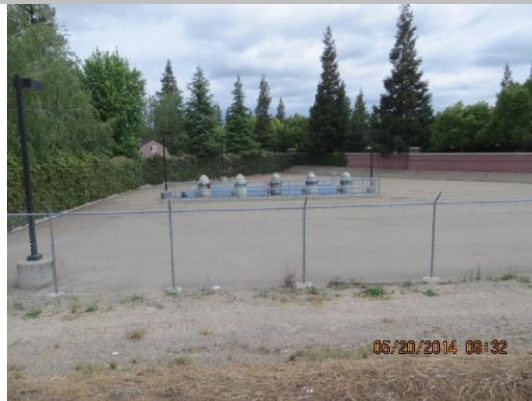
Photo 2 of 2 : UCIP_FA_2019_38093_69304.jpg

Pump over sump off LS toe.

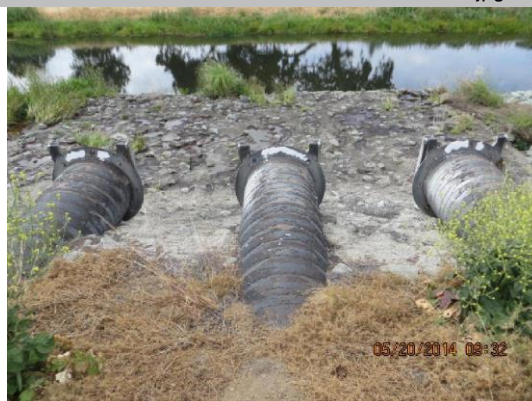
Photo 1 of 2 : UCIP_FA_2019_38086_69291.jpg

Pipe and flapgate visible on WS slope.

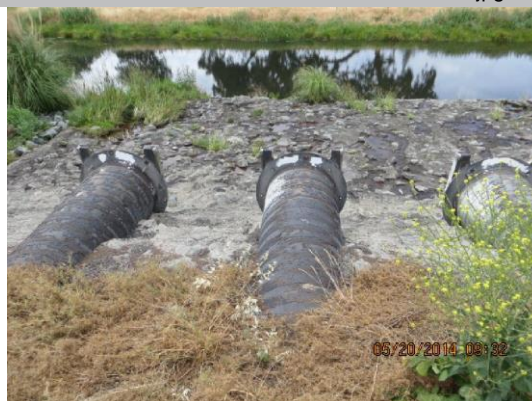
Photo 1 of 2 : UCIP_FA_2019_38089_69297.jpg

Pipe and flapgate visible on WS slope.

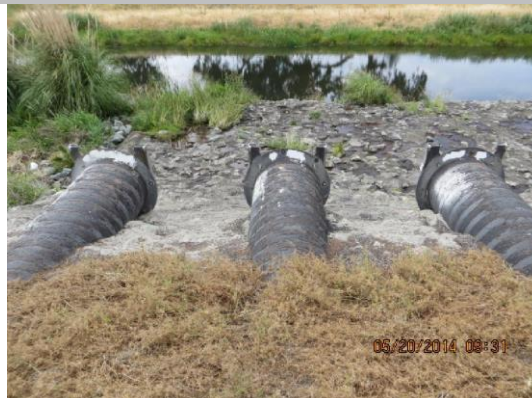
Photo 1 of 2 : UCIP_FA_2019_38088_69295.jpg

Pipe and flapgate on WS slope.

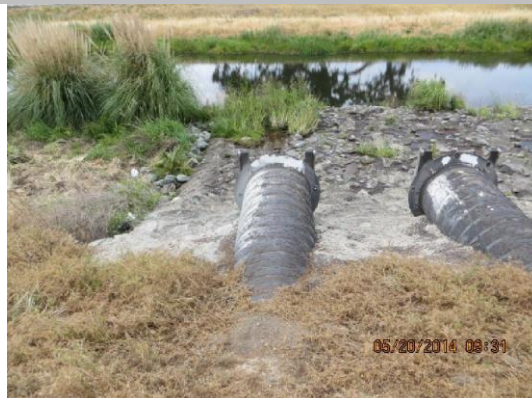
Photo 1 of 2 : UCIP_FA_2019_38087_69293.jpg

Pipe and flapgate on WS slope.

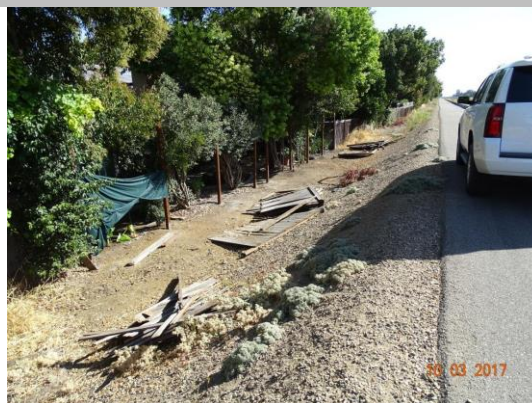
Photo 1 of 1 : FA_2019_NA0017_151_141_20190830_00032.jpg

LM Start	1.55	Rating **	M	Issue No.	141
LM End	1.55	Issue Type +	Ma	Location *	LS
Category	Earthen Levee			GPS Latitude/Longitude	
				Start	End
Item	Encroachments			38.043300 °	38.043300 °
				-121.345242 °	-121.345242 °
DWR ID	DWR_NA0017_07_f_2017_141				
Comment Code					
DE : Debris					
Inspector Comment					
Fence material is located at the landside toe.

View of debris on the landside slope of the levee looking upstream. Fall 2017

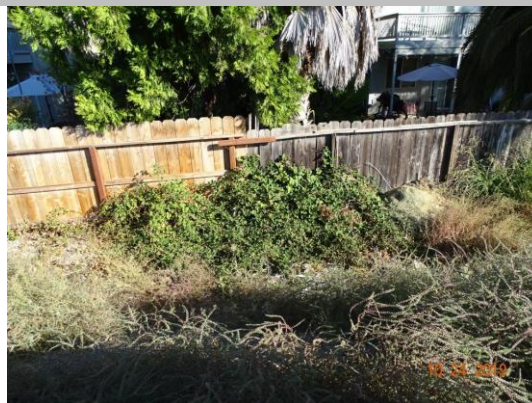
Photo 1 of 1 : FA_2019_NA0017_151_158_20191117_00343.jpg

LM Start	1.79	Rating **	U	Issue No.	158
LM End	1.79	Issue Type +	Ma	Location *	LS
Category	Earthen Levee			GPS Latitude/Longitude	
				Start	End
Item	Vegetation			38.043256 °	38.043256 °
				-121.340769 °	-121.340769 °
DWR ID	DWR_NA0017_07_f_2019_158				
Comment Code					
V2 : Remove the wild growth other than native grasses from the levee slopes.					
Inspector Comment					
Thick berry bushes are covering landside slope.

View of thick berry bushes on landside slope. Fall 2019

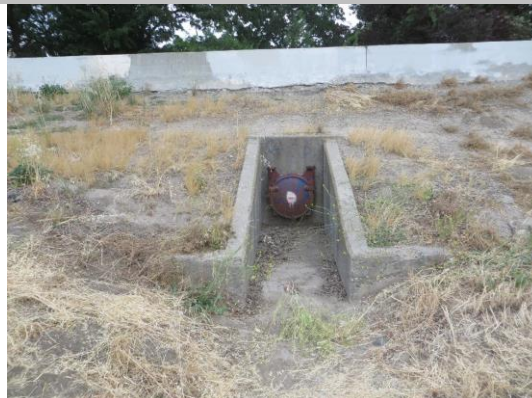
Photo 1 of 3 : UCIP_FA_2019_38024_69205.jpg

Headwall and flapgate on WS toe.

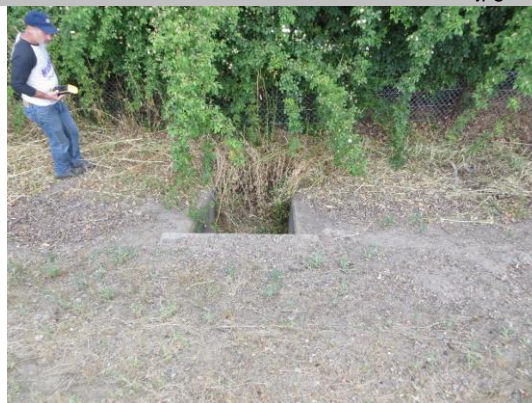
Photo 2 of 3 : UCIP_FA_2019_38024_69204.jpg

Headwall at LS toe.

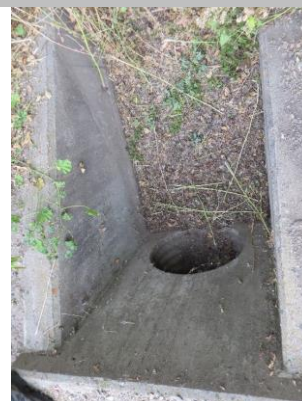
Photo 3 of 3 : UCIP_FA_2019_38024_69203.jpg

Headwall at LS toe.

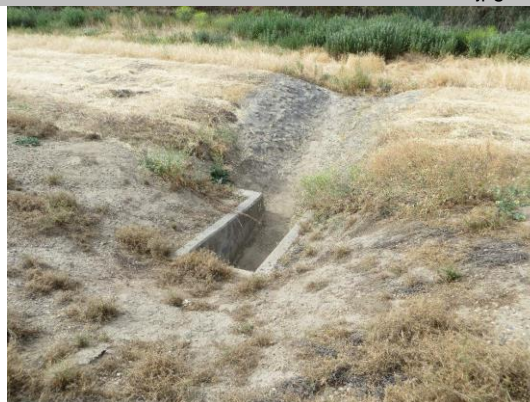
Photo 1 of 3 : UCIP_FA_2019_38006_69190.jpg

Headwall, flapgate, and grouted spillway on WS toe.

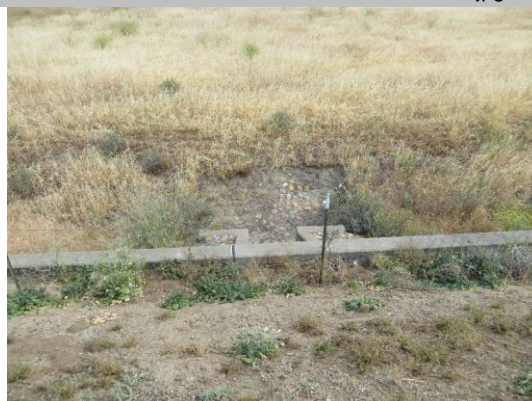
Photo 2 of 3 : UCIP_FA_2019_38006_69189.jpg

Headwall at inlet on LS toe.

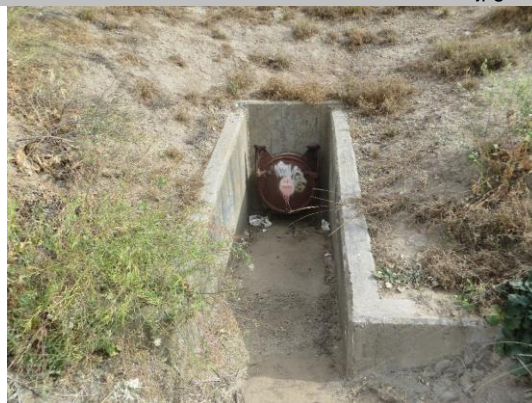
Photo 3 of 3 : UCIP_FA_2019_38006_69188.jpg

Headwall and flapgate at WS toe.

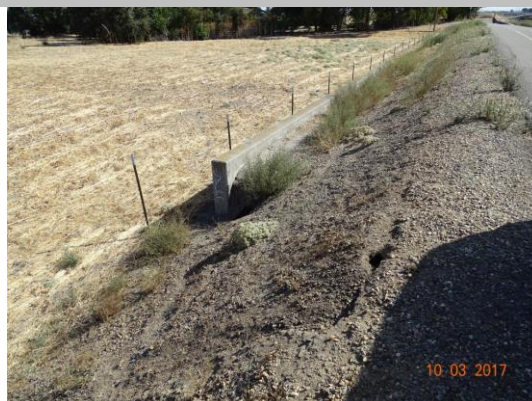
Photo 1 of 1 : FA_2019_NA0017_151_145_20190830_00034.jpg

LM Start	2.71	Rating **	M	Issue No.	145
LM End	2.71	Issue Type +	Ma	Location *	LS
Category	Earthen Levee			GPS Latitude/Longitude	
				Start	End
Item	Animal Control			38.043163 °	38.043163 °
				-121.323913 °	-121.323913 °
DWR ID	DWR_NA0017_07_f_2017_145				
Comment Code					
A3 : No rodents visible, but rodent burrows visible; need to backfill and compact or grout burrows.					
Inspector Comment

View of rodent holes on the landside of the levee looking upstream. Fall 2017

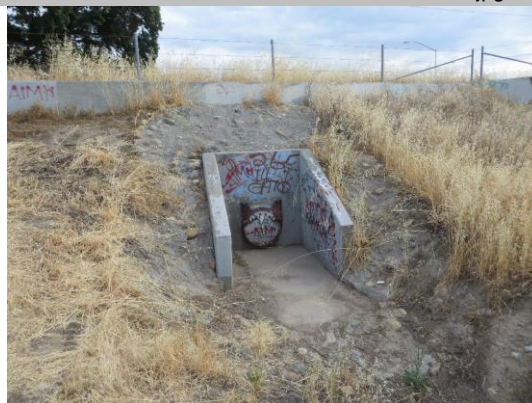
Photo 1 of 3 : UCIP_FA_2019_38004_69184.jpg

Headwall and flapgate on WS slope.

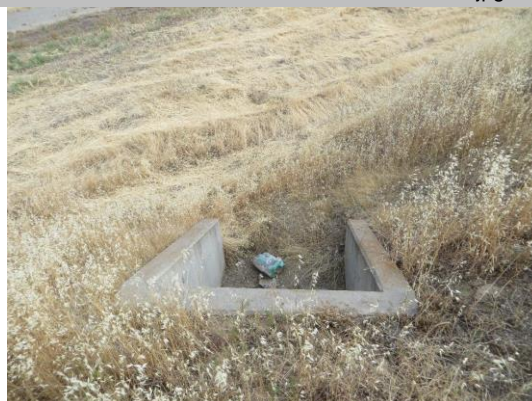
Photo 2 of 3 : UCIP_FA_2019_38004_69183.jpg

Headwall at LS toe.

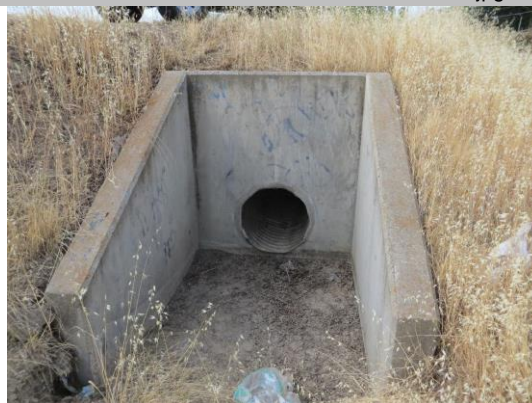
Photo 3 of 3 : UCIP_FA_2019_38004_69182.jpg

Headwall at LS toe.

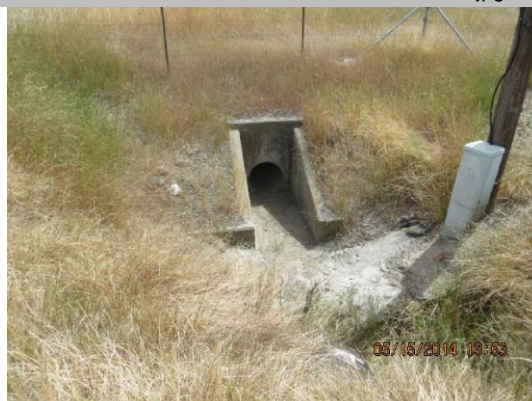
Photo 1 of 3 : UCIP_FA_2019_37999_69164.jpg

Headwall at LS toe.

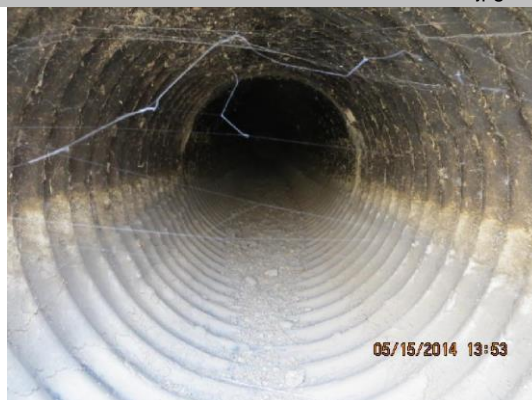
Photo 2 of 3 : UCIP_FA_2019_37999_69163.jpg

Inside pipe at LS toe.

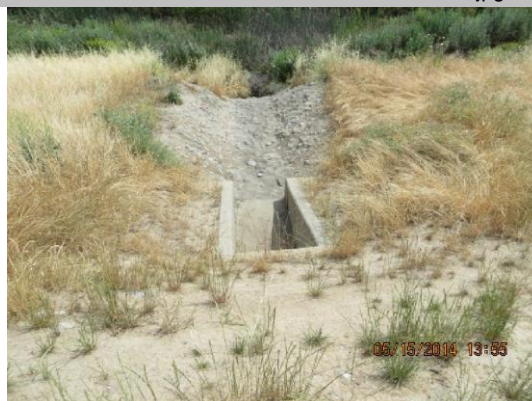
Photo 3 of 3 : UCIP_FA_2019_37999_69162.jpg

Headwall and flapgate at WS toe.

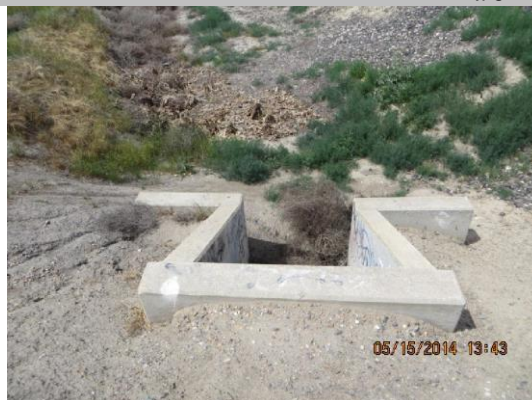
Photo 1 of 3 : UCIP_FA_2019_37998_69160.jpg

Headwall on LS slope.

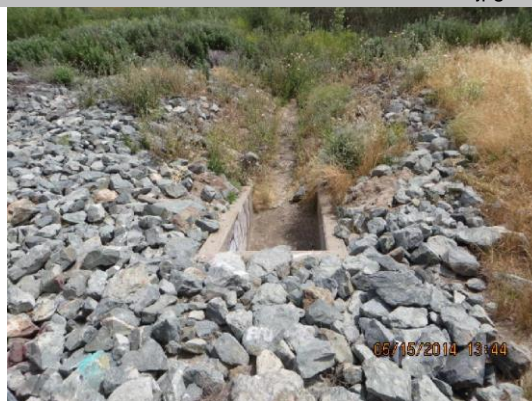
Photo 2 of 3 : UCIP_FA_2019_37998_69159.jpg

Headwall and flapgate on WS toe.

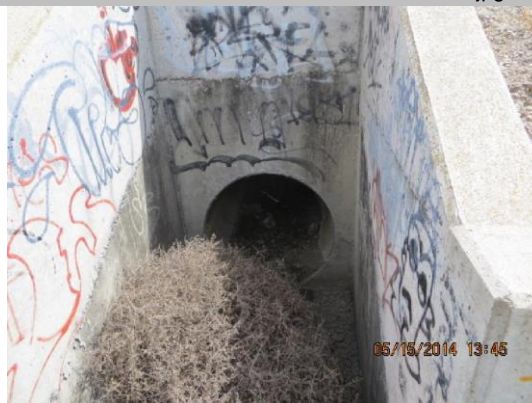
Photo 3 of 3 : UCIP_FA_2019_37998_69158.jpg

Headwall on LS slope.

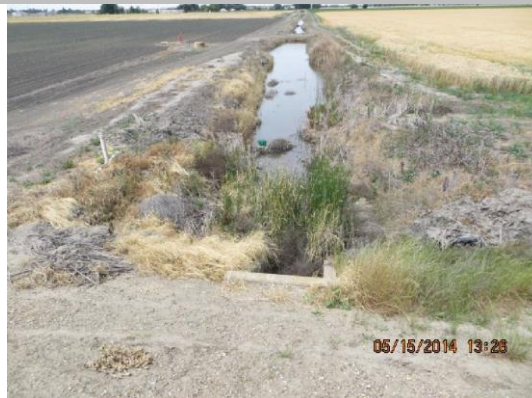
Photo 1 of 3 : UCIP_FA_2019_37991_69144.jpg

Headwall at LS toe.

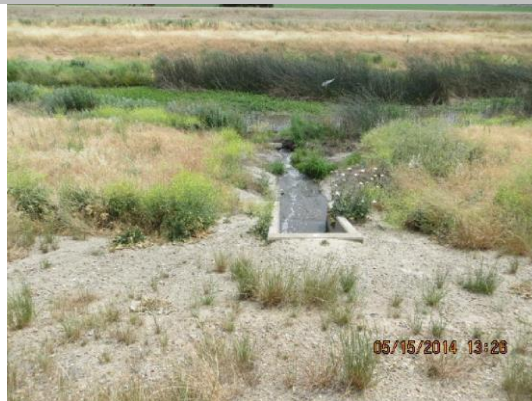
Photo 2 of 3 : UCIP_FA_2019_37991_69143.jpg

Headwall and flapgate at WS toe.

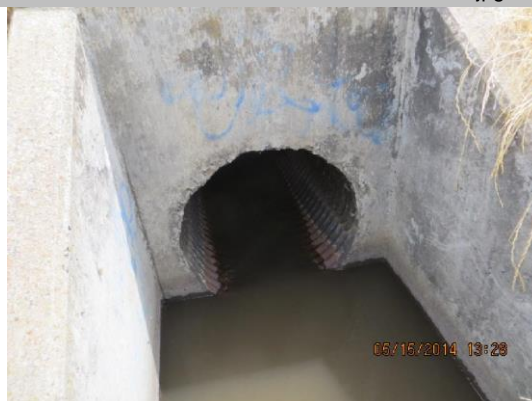
Photo 3 of 3 : UCIP_FA_2019_37991_69142.jpg

Headwall at LS toe.

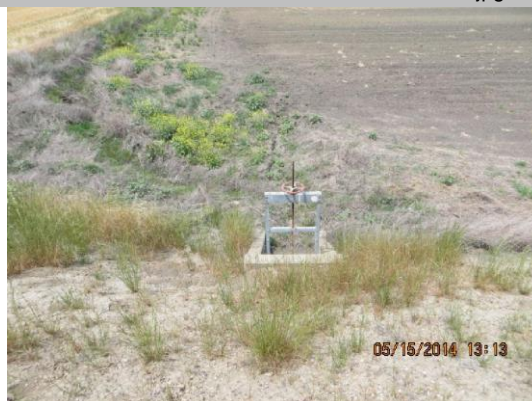
Photo 1 of 3 : UCIP_FA_2019_37988_69139.jpg

Headwall and slidegate on LS toe.

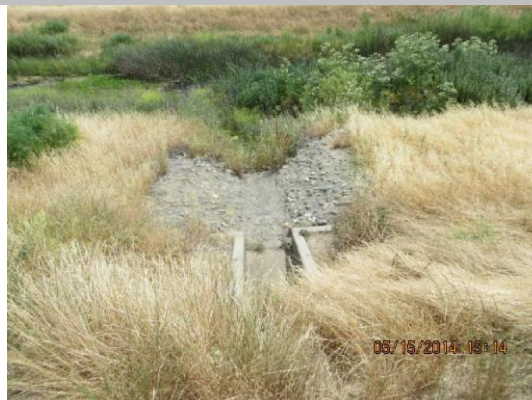
Photo 2 of 3 : UCIP_FA_2019_37988_69138.jpg

Headwall, flapgate, and grouted spillway on WS toe.

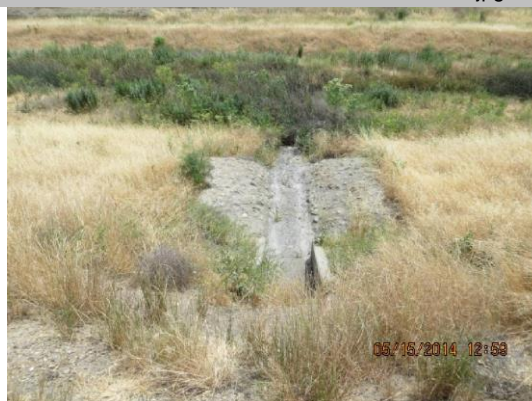
Photo 2 of 3 : UCIP_FA_2019_37984_69128.jpg

Headwall and flapgate at WS toe.

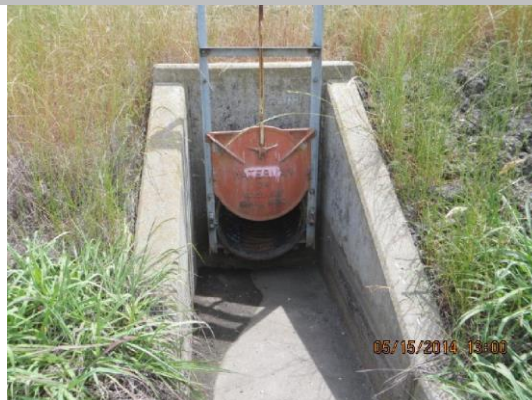
Photo 3 of 3 : UCIP_FA_2019_37984_69127.jpg

Slidegate at headwall on LS toe.

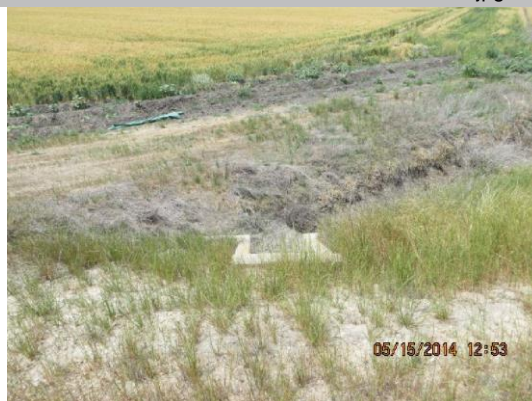
Photo 1 of 3 : UCIP_FA_2019_37982_69125.jpg

Headwall at LS toe.

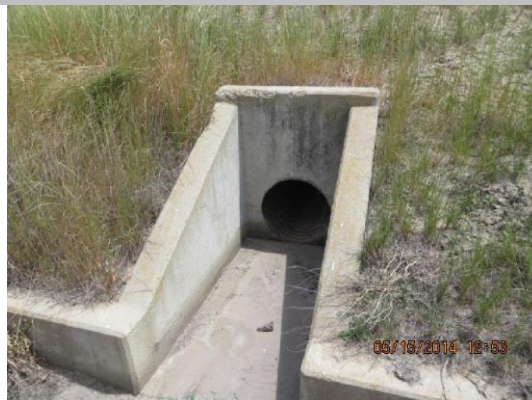
Photo 2 of 3 : UCIP_FA_2019_37982_69124.jpg

Headwall at LS toe.

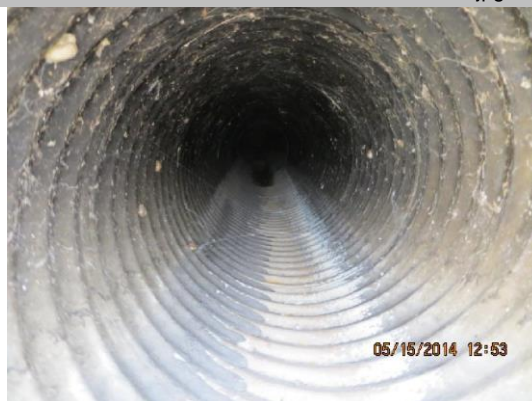
Photo 3 of 3 : UCIP_FA_2019_37982_69123.jpg

Inside pipe at LS toe.

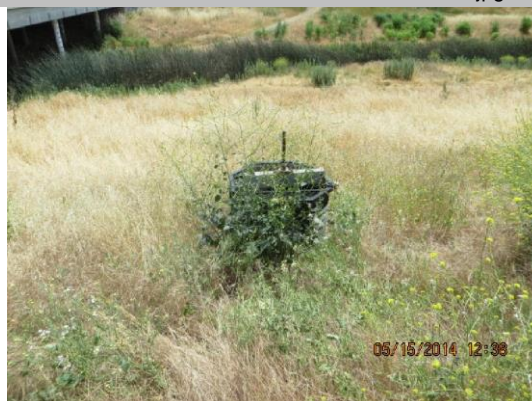
Photo 2 of 3 : UCIP_FA_2019_37981_69121.jpg

Slidegate in CMP riser on WS slope.

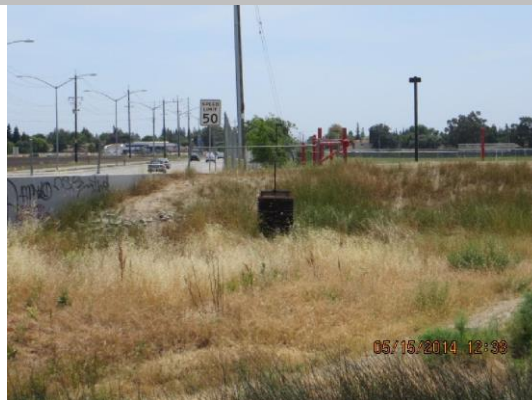
Photo 3 of 3 : UCIP_FA_2019_37981_69120.jpg

Adjoining CMP riser on opposite bank.

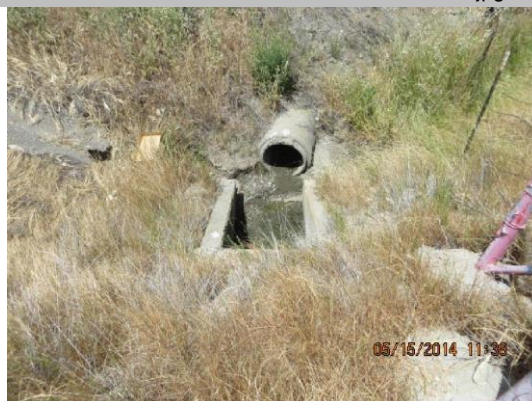
Photo 1 of 3 : UCIP_FA_2019_37973_69105.jpg

Headwall on LS toe.

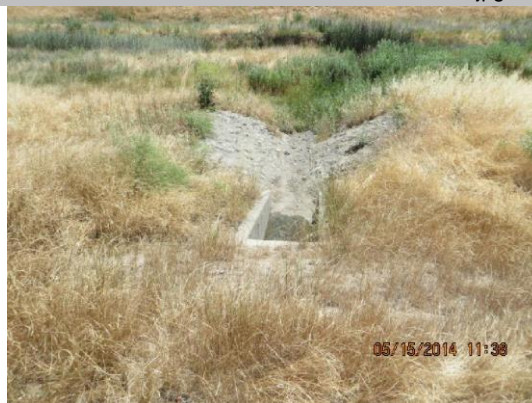
Photo 2 of 3 : UCIP_FA_2019_37973_69104.jpg

Headwall, flapgate, and grouted spillway on WS toe.

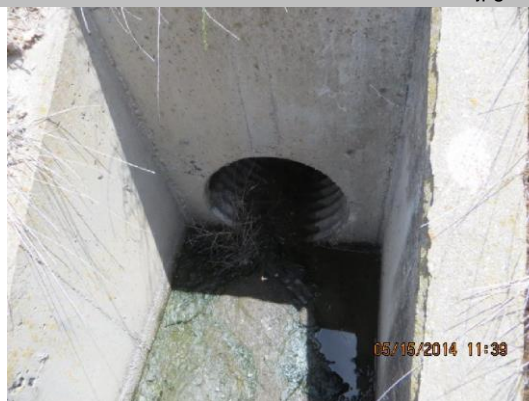
Photo 3 of 3 : UCIP_FA_2019_37973_69103.jpg

Headwall on LS toe.

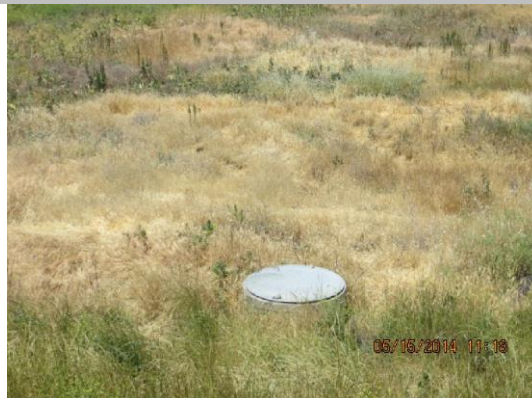
Photo 1 of 3 : UCIP_FA_2019_37967_69085.jpg

Concrete standpipe on LS toe.

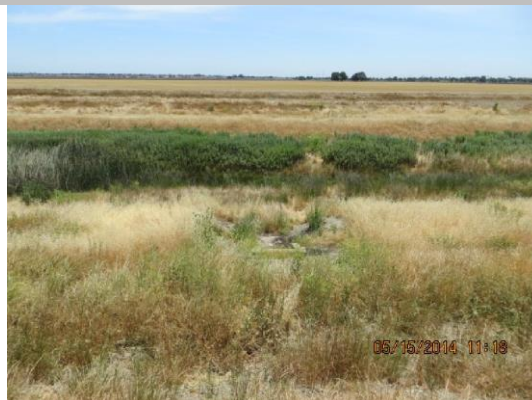
Photo 2 of 3 : UCIP_FA_2019_37967_69084.jpg

Headwall and flapgate on WS toe.

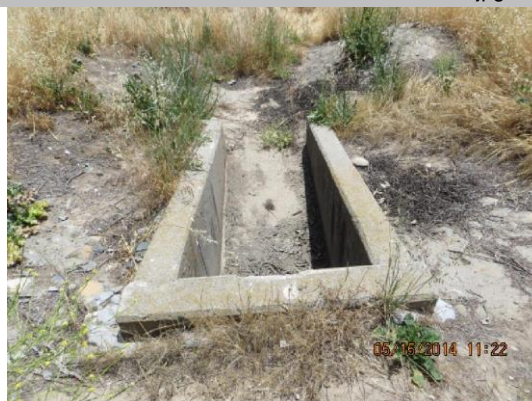
Photo 3 of 3 : UCIP_FA_2019_37967_69083.jpg

Headwall and flapgate on WS toe.

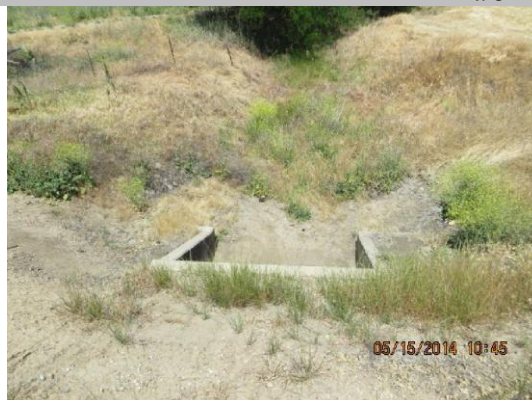
Photo 1 of 3 : UCIP_FA_2019_37957_69055.jpg

Headwall on LS toe.

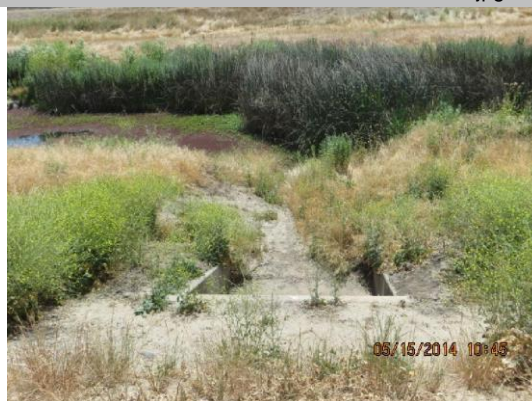
Photo 2 of 3 : UCIP_FA_2019_37957_69054.jpg

Headwall and flapgate on WS toe.

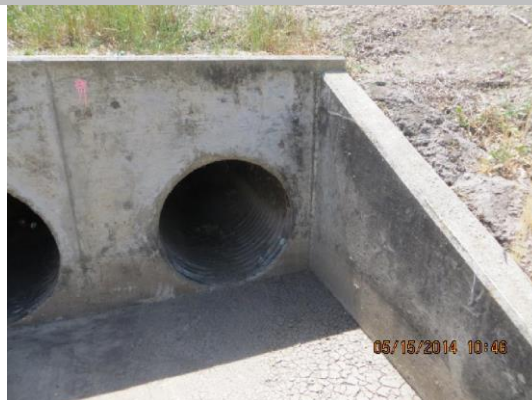
Photo 3 of 3 : UCIP_FA_2019_37957_69053.jpg

Headwall on LS toe.

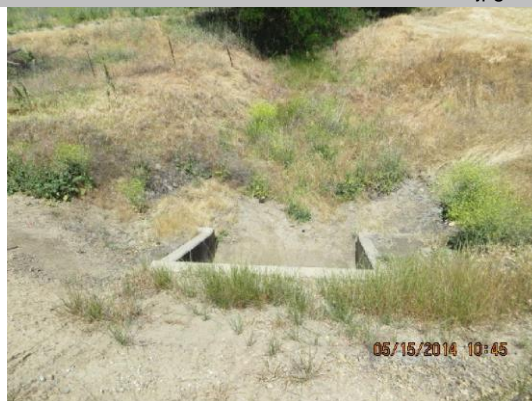
Photo 1 of 3 : UCIP_FA_2019_41807_69050.jpg

Concrete headwall on LS toe.
