**Flood Control Project Maintenance
Levee Inspections**

Maintenance Issue Types Only, Levee Inspection Report By Mile - Fall 2019

San Joaquin County Flood Control and Water Conservation District

Waterway	Bank	Unit Miles	Inspection Start/End	Inspector
Unit No. 01 Littlejohn Creek	Left	2.59	11/14/2019 11/14/2019	Alberto De Leon

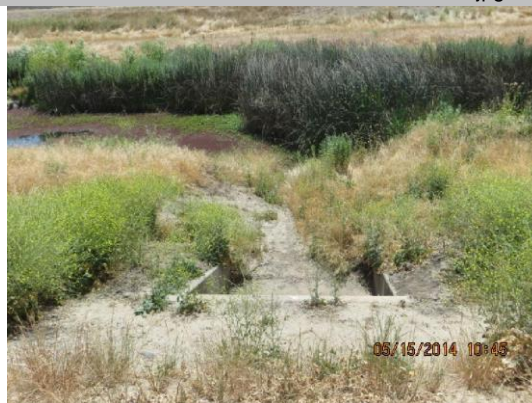
Photo 2 of 3 : UCIP_FA_2019_41807_69049.jpg

Headwall and flapgate on WS toe.

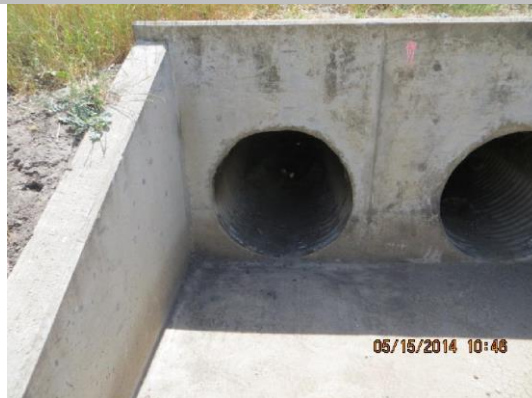
Photo 3 of 3 : UCIP_FA_2019_41807_69048.jpg

Headwall at LS toe.

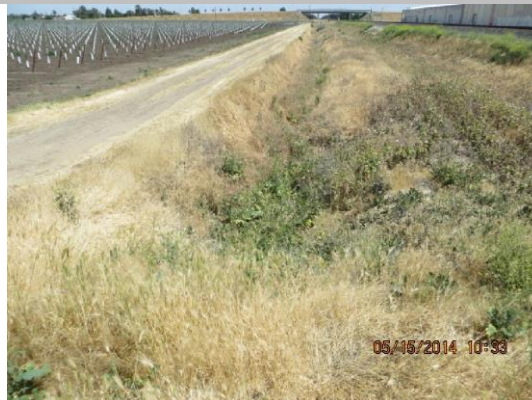
Photo 1 of 3 : UCIP_FA_2019_37885_68913.jpg

Pipe in channel on LS toe.

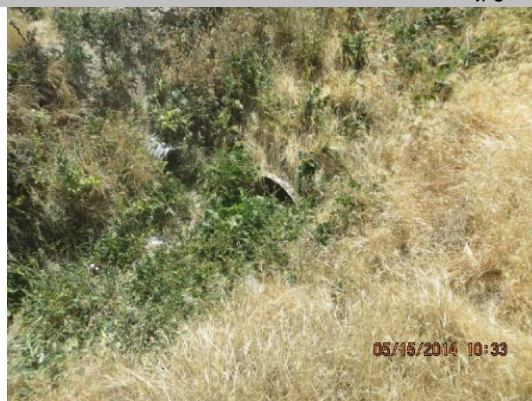
Photo 2 of 3 : UCIP_FA_2019_37885_68912.jpg

Pipe in channel on LS toe.

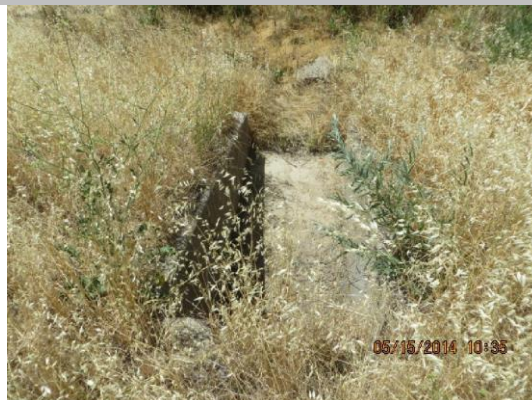
Photo 3 of 3 : UCIP_FA_2019_37885_68911.jpg

Flapgate and headwall at WS toe.

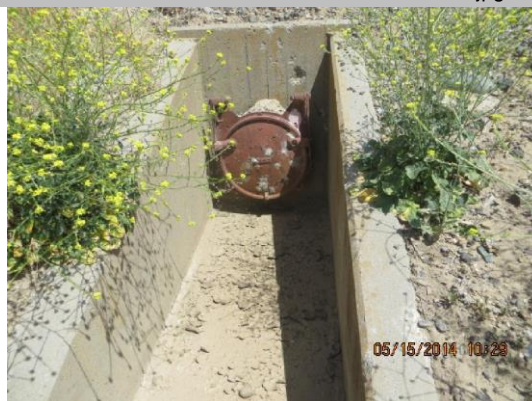
Photo 1 of 3 : UCIP_FA_2019_41801_68902.jpg

Headwall and flapgate on WS toe.

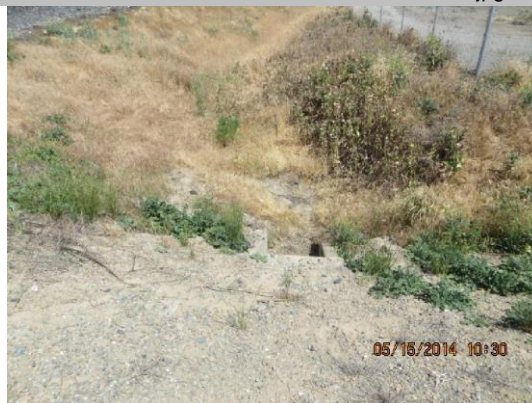
Photo 2 of 3 : UCIP_FA_2019_41801_68901.jpg

Headwall on LS toe.

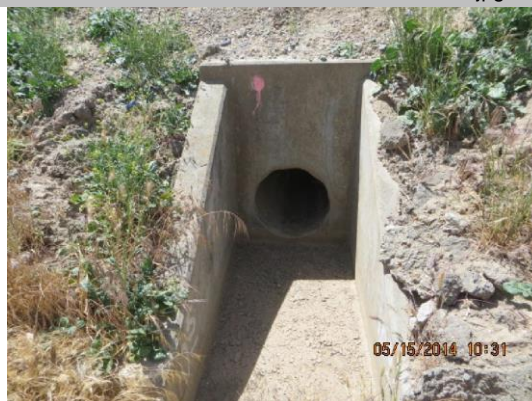
Photo 3 of 3 : UCIP_FA_2019_41801_68900.jpg

Headwall on LS toe.

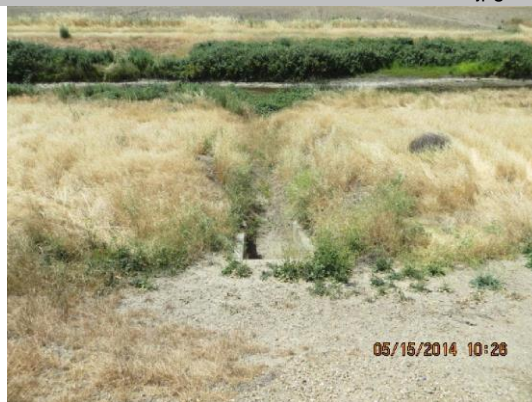
Photo 1 of 2 : UCIP_FA_2019_40213_68899.jpg

Headwall and flapgate at WS toe.

Comment Code						
Inspector Comment						
DS_ID:23546						
FS_ID:40213						
EP_NO: N/A						
Repair Type: Non-Urgent						
Crossing Status: Found						
UCIP Comments: Inlet burried at LS toe. Pipe may be abandoned and if so should be done so properly.						
FIELD_STRUCT_DESC: *ABANDONED* 36-inch corrugated metal drainage pipe through the levee, 7.9 feet below the crown. Concrete U-shaped headwall on the waterside (WS) end. Concrete headwall on the landside (LS). Flap gate on the WS end. Cobble grouted spillway across the berm. [Additional Reference(s): DWR Levee Log, 1987. USACE San Joaquin O&M Manual 612.1, June 1965, (HLM 5.97)].						
FS Date: 5/15/2014

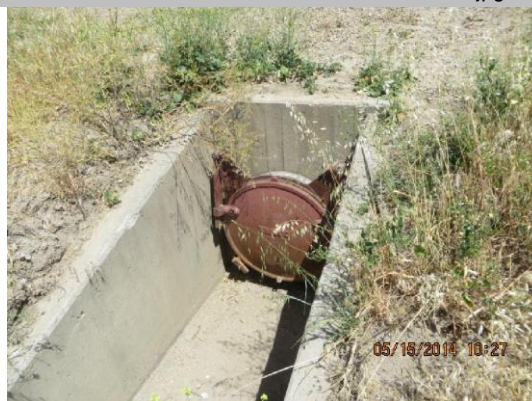
Photo 2 of 2 : UCIP_FA_2019_40213_68898.jpg

Headwall and flapgate at WS toe.

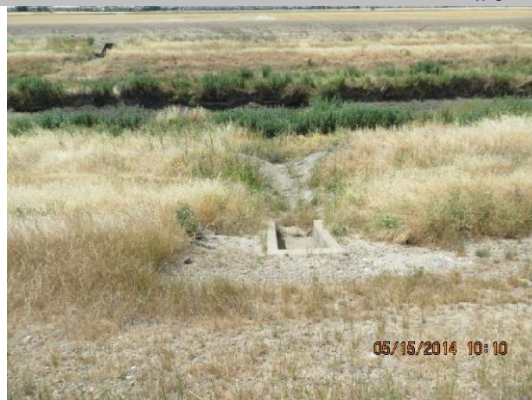
Photo 1 of 3 : UCIP_FA_2019_37874_68894.jpg

Headwall, flapgate, and grouted spillway on WS toe.

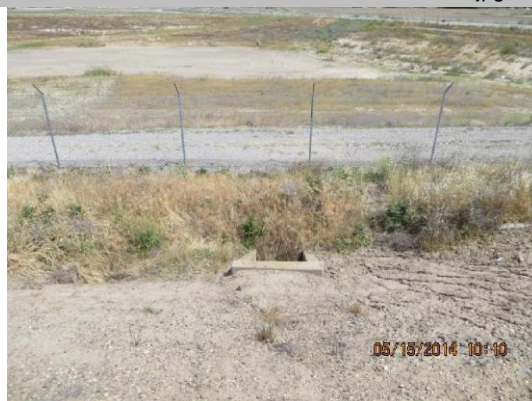
Photo 2 of 3 : UCIP_FA_2019_37874_68893.jpg

Headwall on LS toe.

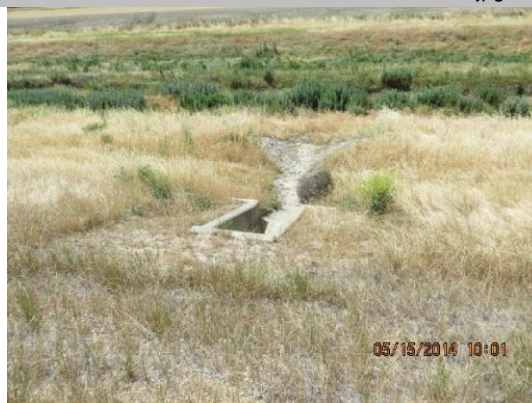
Photo 1 of 3 : UCIP_FA_2019_41802_68885.jpg

Comment Code						
Inspector Comment						
DS_ID:23551 FS_ID:41802 EP_NO: N/A Repair Type: Non-Urgent Crossing Status: Found UCIP Comments: Sediment buildup in pipe at LS toe. FIELD_STRUCT_DESC: 24-inch corrugated metal storm drainage pipe through the levee, 5.5 feet below the crown. Concrete U-shaped headwalls on both ends. Flap gate on the waterside (WS) end. Grouted intake on the landside (LS). Cobble grouted spillway across the berm. [Additional Reference(s): DWR Levee Log, 1987. USACE San Joaquin O&M Manual 612.1, June 1965, (HLM 6.32) and 612 (addendum), February 1999, (HLM 6.34) (Station 334+54), listed as a 36-inch pipe]. FS Date: 5/15/2014

Headwall and flapgate on WS toe.

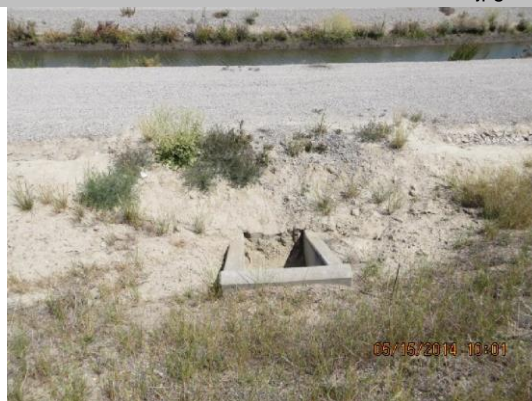
Photo 2 of 3 : UCIP_FA_2019_41802_68884.jpg

Comment Code						
Inspector Comment						
DS_ID:23551 FS_ID:41802 EP_NO: N/A Repair Type: Non-Urgent Crossing Status: Found UCIP Comments: Sediment buildup in pipe at LS toe. FIELD_STRUCT_DESC: 24-inch corrugated metal storm drainage pipe through the levee, 5.5 feet below the crown. Concrete U-shaped headwalls on both ends. Flap gate on the waterside (WS) end. Grouted intake on the landside (LS). Cobble grouted spillway across the berm. [Additional Reference(s): DWR Levee Log, 1987. USACE San Joaquin O&M Manual 612.1, June 1965, (HLM 6.32) and 612 (addendum), February 1999, (HLM 6.34) (Station 334+54), listed as a 36-inch pipe]. FS Date: 5/15/2014

Headwall on LS toe.

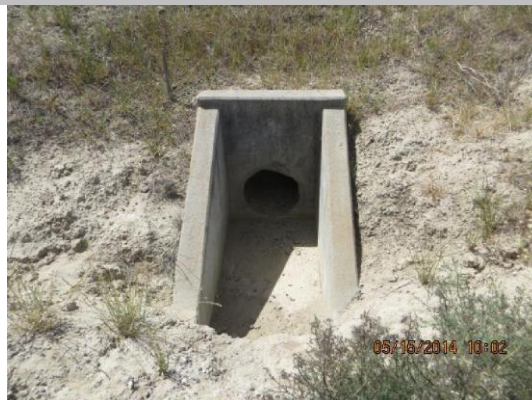
Photo 3 of 3 : UCIP_FA_2019_41802_68883.jpg

Headwall on LS toe.

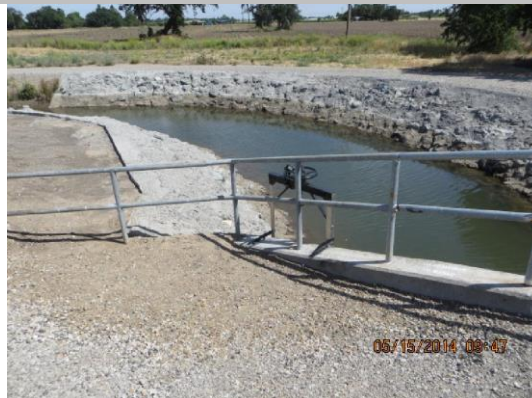
Photo 1 of 3 : UCIP_FA_2019_40208_68881.jpg

Slide gate on headwall at pipe on LS toe.

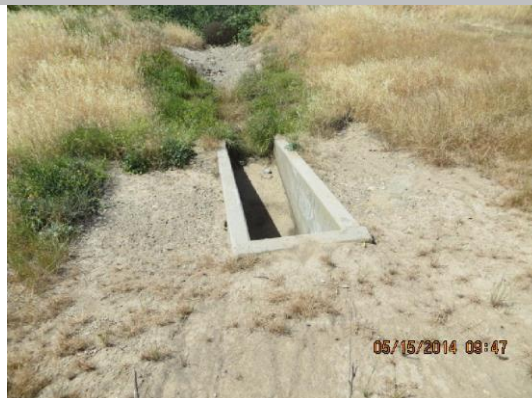
Photo 2 of 3 : UCIP_FA_2019_40208_68880.jpg

Flapgate and headwall on WS toe.

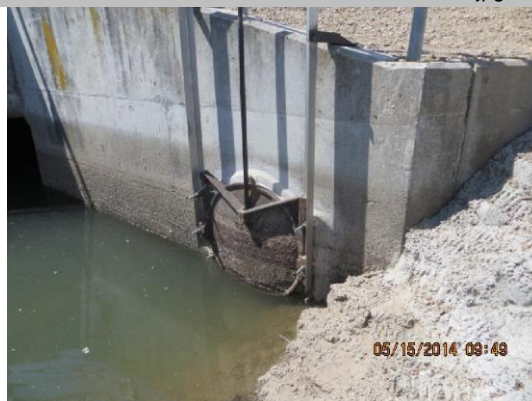
Photo 3 of 3 : UCIP_FA_2019_40208_68879.jpg

Slide gate on headwall at pipe on LS toe.

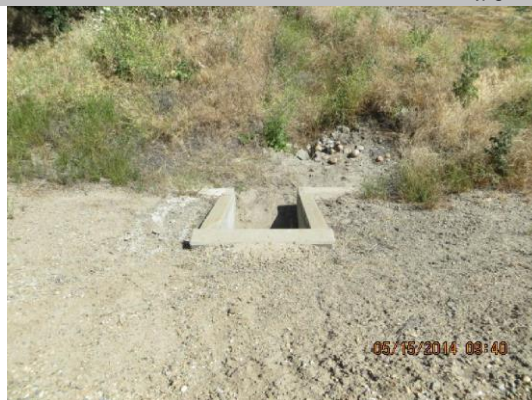
Photo 1 of 3 : UCIP_FA_2019_37852_68873.jpg

LM Start	6.13	Rating **	A/W	Issue No.	1090
LM End	6.13	Issue Type +	Ma	Location *	
Category	Supplemental			GPS Latitude/Longitude	
				Start	End
Item	DRAFT DWR UCIP LMA Responsibility			38.054497 °	38.054497 °
				-121.266387 °	-121.266387 °
DWR ID	23554				
Comment Code					
Inspector Comment					
DS_ID:23554					
FS_ID:37852					
EP_NO: N/A					
Repair Type: No Action Needed					
Crossing Status: Found					
UCIP Comments:					
FIELD_STRUCT_DESC: 24-inch corrugated metal drainage pipe through the levee, 5.3 feet below the crown. Concrete U-shaped headwalls on both ends. Flap gate on the waterside (WS) end. Grouted intake on the landside (LS). Cobble grouted spillway across the berm. [Additional Reference(s): DWR Levee Log, 1987. USACE San Joaquin O&M Manual 612.1, June 1965, (HLM 6.53)].					
FS Date: 5/15/2014

Headwall on LS toe.

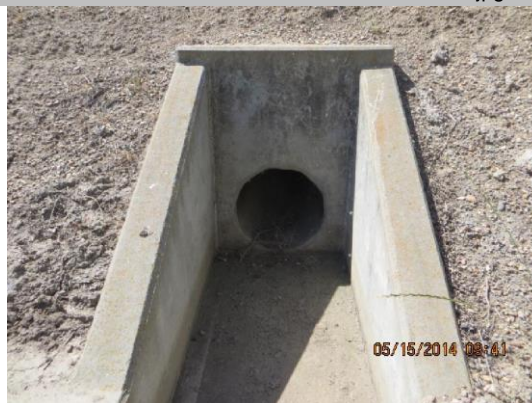
Photo 3 of 3 : UCIP_FA_2019_37852_68871.jpg

Headwall on LS toe.

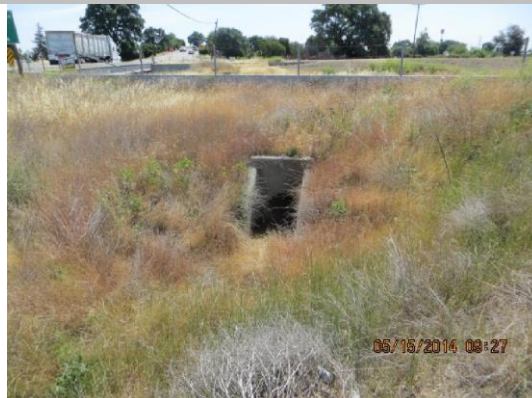
Photo 1 of 3 : UCIP_FA_2019_37849_68868.jpg

LM Start	6.44	Rating **	A/W	Issue No.	1091
LM End	6.44	Issue Type +	Ma	Location *	
Category	Supplemental			GPS Latitude/Longitude	
				Start	End
Item	DRAFT DWR UCIP LMA Responsibility			38.057275 °	38.057275 °
				-121.262193 °	-121.262193 °
DWR ID	23555				
Comment Code					
Inspector Comment					
DS_ID:23555 FS_ID:37849 EP_NO: N/A Repair Type: No Action Needed Crossing Status: Found UCIP Comments: FIELD_STRUCT_DESC: 24-inch corrugated metal drainage pipe through the levee, 6.7 feet below the crown. Concrete U-shaped headwalls on both ends. Flap gate on the waterside (WS) end. Grouted intake on the landside (LS). Cobble grouted spillway across the berm. [Additional Reference(s): DWR Levee Log, 1987. USACE San Joaquin O&M Manual 612.1, June 1965, (HLM 6.85)]. FS Date: 5/15/2014

Pipe and headwall on LS toe.

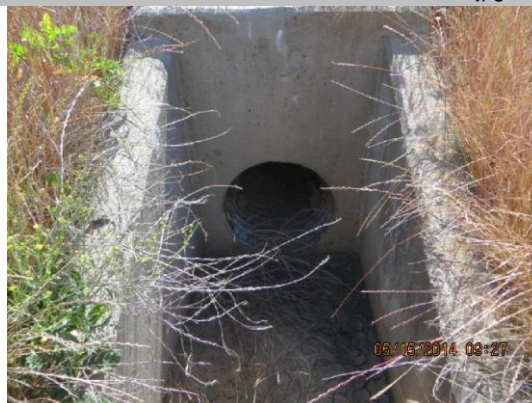
Photo 2 of 3 : UCIP_FA_2019_37849_68867.jpg

Pipe and headwall on LS toe.

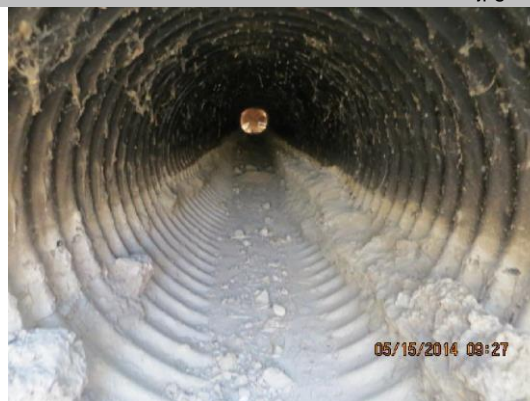
Photo 3 of 3 : UCIP_FA_2019_37849_68866.jpg

Inside pipe at LS toe.

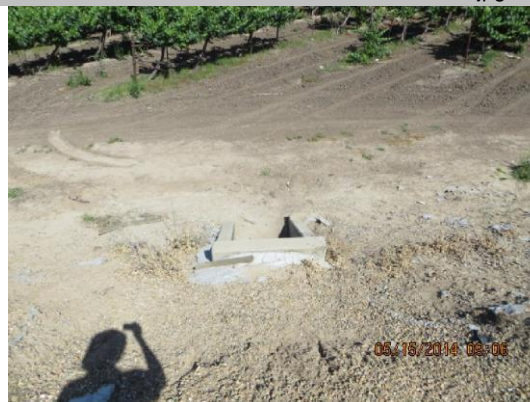
Photo 1 of 3 : UCIP_FA_2019_37847_68860.jpg

Comment Code						
Inspector Comment						
DS_ID:23557						
FS_ID:37847						
EP_NO: N/A						
Repair Type: No Action Needed						
Crossing Status: Found						
UCIP Comments:						
FIELD_STRUCT_DESC: 24-inch corrugated metal storm drainage pipe through the levee, 6.5 feet below the crown. Concrete U-shaped headwalls on both ends. Flap gate on the waterside (WS) end. Cobble grouted spillway across the berm. Culvert with slide gate in WID headwall on the WS. [Additional Reference(s): DWR Levee Log, 1987. USACE San Joaquin O&M Manual 612.1, June 1965, (HLM 7.02) and 612 (addendum), February 1999, (HLM 6.97) (Station 368+08)].						
FS Date: 5/15/2014

Pipe and headwall on LS toe.

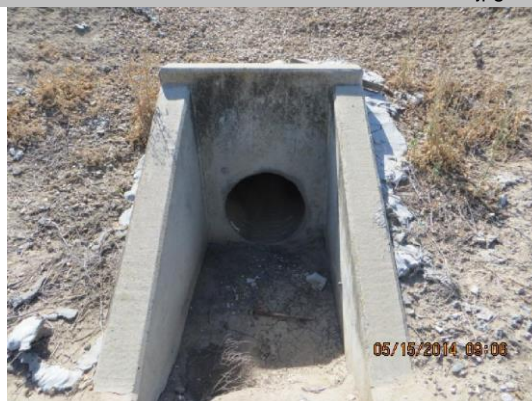
Photo 2 of 3 : UCIP_FA_2019_37847_68859.jpg

Pipe and headwall on LS toe.

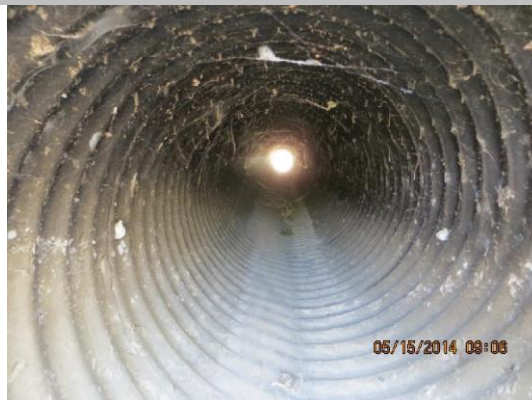
Photo 3 of 3 : UCIP_FA_2019_37847_68858.jpg

Inside pipe on LS toe.

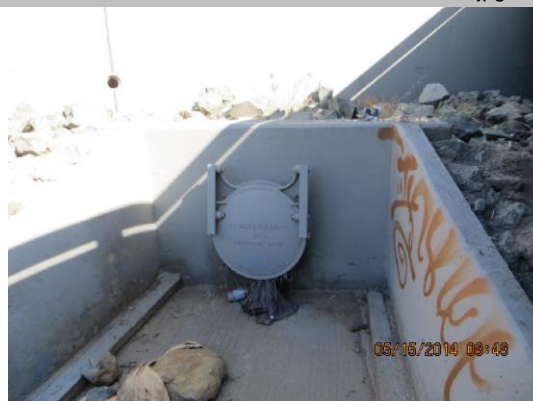
Photo 1 of 1 : UCIP_FA_2019_40207_68857.jpg

LM Start	6.76	Rating **	A/W	Issue No.	1096	
LM End	6.76	Issue Type +	Ma	Location *		
Category	Supplemental			GPS Latitude/Longitude		
				Start		End
Item	DRAFT DWR UCIP LMA Responsibility			38.061050 °		38.061050 °
				-121.259836 °		-121.259836 °
DWR ID	23559					
Comment Code						
Inspector Comment						
DS_ID:23559 FS_ID:40207 EP_NO: N/A Repair Type: No Action Needed Crossing Status: Found UCIP Comments: FIELD_STRUCT_DESC: 24-inch corrugated metal drainage pipe through the levee, 9 feet below the crown. Concrete U-shaped headwalls on both ends. Flap gate on the waterside (WS) end. Cobble grouted spillway across berm. Cobble grouted apron on the landside (LS) end. [Additional Reference(s): DWR Levee Log, 1987. USACE San Joaquin O&M Manual 612.1, June 1965, (HLM 7.14) 8-inch pipe listed]. FS Date: 5/15/2014

Pipe, headwall, and flapgate on WS toe.

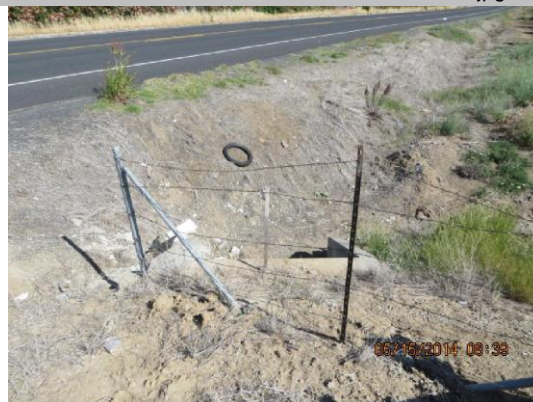
Photo 1 of 3 : UCIP_FA_2019_37844_68853.jpg

LM Start	6.82	Rating **	A/W	Issue No.	1097
LM End	6.82	Issue Type +	Ma	Location *	
Category	Supplemental			GPS Latitude/Longitude	
				Start	End
Item	DRAFT DWR UCIP LMA Responsibility			38.061678 °	38.061678 °
				-121.259084 °	-121.259084 °
DWR ID	23561				
Comment Code					
Inspector Comment					
DS_ID:23561 FS_ID:37844 EP_NO: N/A Repair Type: No Action Needed Crossing Status: Found UCIP Comments: FIELD_STRUCT_DESC: 36-inch concrete drainage pipe through the levee, 8 feet below the crown. Concrete U-shaped headwalls on both ends. Flap gate on the waterside (WS) end. Cobble grouted spillway across berm. Cobble grouted apron on the landside (LS) end. [Additional Reference(s): DWR Levee Log, 1987. USACE San Joaquin O&M Manual 612.2, 1967, (HLM 7.21)]. FS Date: 5/15/2014

Pipe and headwall on LS toe.

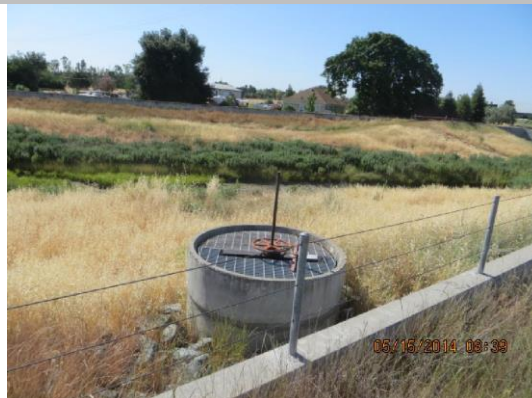
Photo 2 of 3 : UCIP_FA_2019_37844_68852.jpg

Slide gate in a 72-inch concrete riser on WS slope.

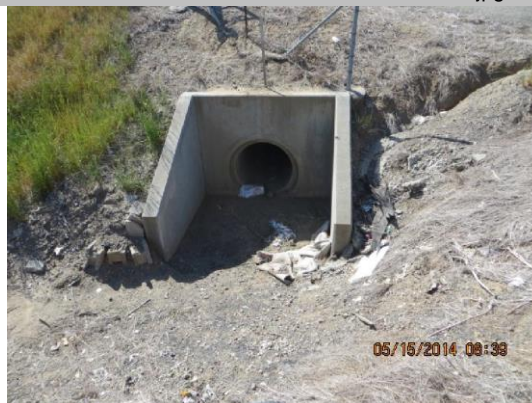
Photo 3 of 3 : UCIP_FA_2019_37844_68851.jpg

Pipe and headwall on LS toe.

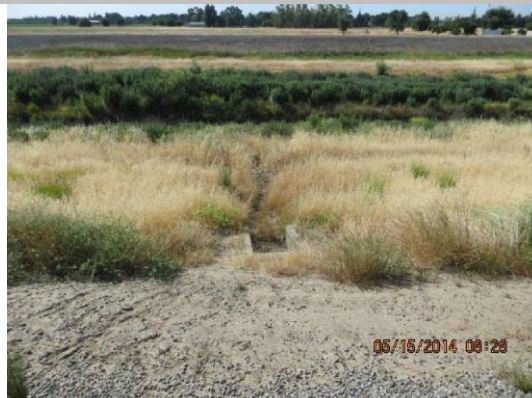
Photo 1 of 3 : UCIP_FA_2019_37842_68848.jpg

LM Start	6.95	Rating **	A/W	Issue No.	1098	
LM End	6.95	Issue Type +	Ma	Location *		
Category	Supplemental			GPS Latitude/Longitude		
				Start		End
Item	DRAFT DWR UCIP LMA Responsibility			38.062847 °		38.062847 °
				-121.257143 °		-121.257143 °
DWR ID	23562					
Comment Code						
Inspector Comment						
DS_ID:23562 FS_ID:37842 EP_NO: N/A Repair Type: No Action Needed Crossing Status: Found UCIP Comments: FIELD_STRUCT_DESC: 24-inch corrugated metal storm drainage pipe through the levee, 8 feet below the crown. Concrete U-shaped headwalls on both ends. Flap gate on the waterside (WS) end. Cobble grouted spillway across the berm. Cobble grouted apron on the landside (LS) end. [Additional Reference(s): DWR Levee Log, 1987. USACE San Joaquin O&M Manual 612.2, 1967, (HLM 7.34) and 612 (addendum), February 1999, (HLM 7.30) (Station 385+65)]. FS Date: 5/15/2014

Headwall, pipe, flapgate, and grouted spillway on WS toe.

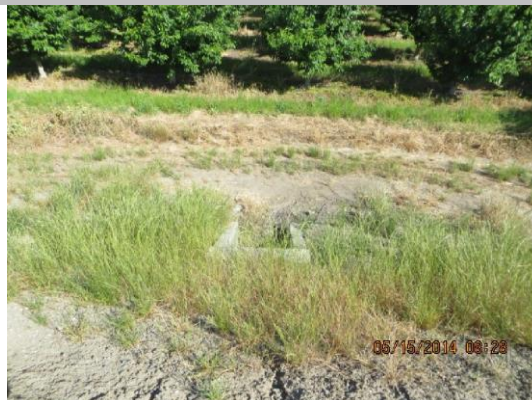
Photo 2 of 3 : UCIP_FA_2019_37842_68847.jpg

Pipe and headwall on LS toe.

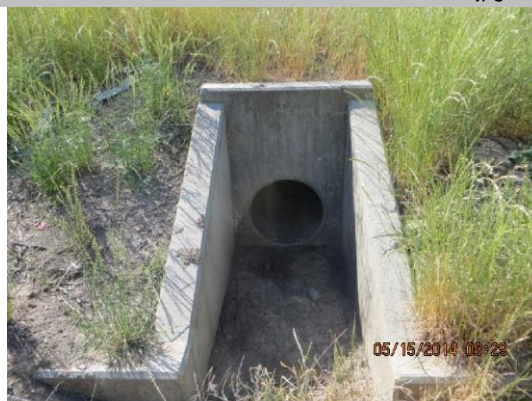
Photo 3 of 3 : UCIP_FA_2019_37842_68846.jpg

Pipe and headwall on LS toe.

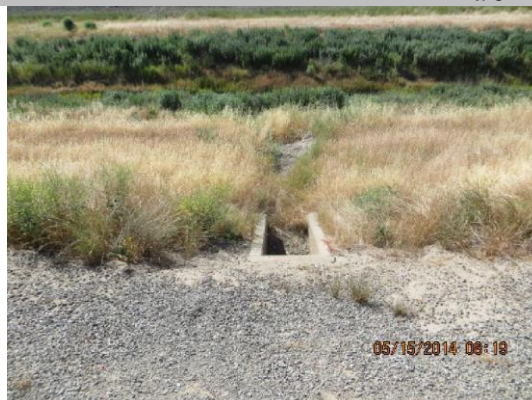
Photo 1 of 3 : UCIP_FA_2019_37841_68843.jpg

LM Start	7.11	Rating **	A/W	Issue No.	1099
LM End	7.11	Issue Type +	Ma	Location *	
Category	Supplemental			GPS Latitude/Longitude	
				Start	End
Item	DRAFT DWR UCIP LMA Responsibility			38.064076 °	38.064076 °
				-121.254656 °	-121.254656 °
DWR ID	23563				
Comment Code					
Inspector Comment					
DS_ID:23563					
FS_ID:37841					
EP_NO: N/A					
Repair Type: No Action Needed					
Crossing Status: Found					
UCIP Comments:					
FIELD_STRUCT_DESC: 24-inch corrugated metal storm drainage pipe through the levee, 7 feet below the crown. Concrete U-shaped headwalls on both ends. Flap gate on the waterside (WS) end. Cobble grouted spillway across berm. Cobble grouted apron on the landside (LS) end. [Additional Reference(s): DWR Levee Log, 1987. USACE San Joaquin O&M Manual 612.2, 1967, (HLM 7.51) and 612 (addendum), February 1999, (HLM 7.45) (Station 393+26)].					
FS Date: 5/15/2014

Pipe, headwall, flapgate, and grouted spillway on WS toe.

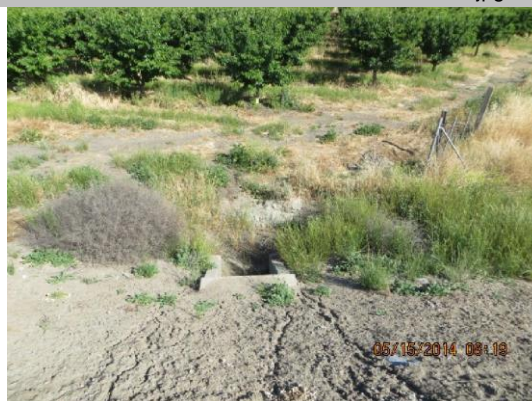
Photo 2 of 3 : UCIP_FA_2019_37841_68842.jpg

Pipe and headwall at LS toe.

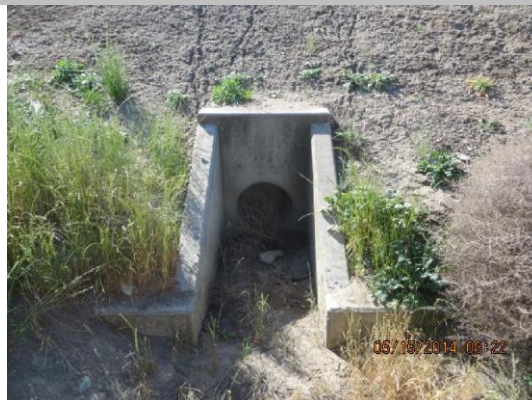
Photo 3 of 3 : UCIP_FA_2019_37841_68841.jpg

Pipe and headwall at LS toe.

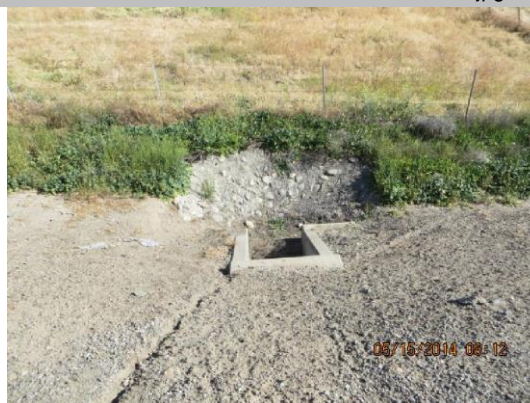
Photo 1 of 3 : UCIP_FA_2019_37840_68838.jpg

LM Start	7.31	Rating **	A/W	Issue No.	1100
LM End	7.31	Issue Type +	Ma	Location *	
Category	Supplemental			GPS Latitude/Longitude	
				Start	End
Item	DRAFT DWR UCIP LMA Responsibility			38.064970 °	38.064970 °
				-121.251261 °	-121.251261 °
DWR ID	23564				
Comment Code					
Inspector Comment					
DS_ID:23564					
FS_ID:37840					
EP_NO: N/A					
Repair Type: No Action Needed					
Crossing Status: Found					
UCIP Comments:					
FIELD_STRUCT_DESC: 24-inch corrugated metal drainage pipe through the levee, 7.5 feet below the crown. Concrete U-shaped headwalls on both ends. Flap gate on the waterside (WS) end. Cobble grouted spillway across the berm. Cobble grouted apron on the landside (LS) end. [Additional Reference(s): DWR Levee Log, 1987. USACE San Joaquin O&M Manual 612.2, 1967, (HLM 7.72)].					
FS Date: 5/15/2014

Pipe and headwall on LS toe.

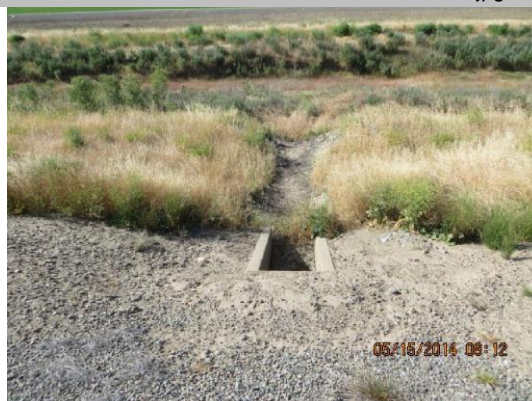
Photo 2 of 3 : UCIP_FA_2019_37840_68837.jpg

Pipe, headwall, flapgate, and grouted spillway on WS toe.

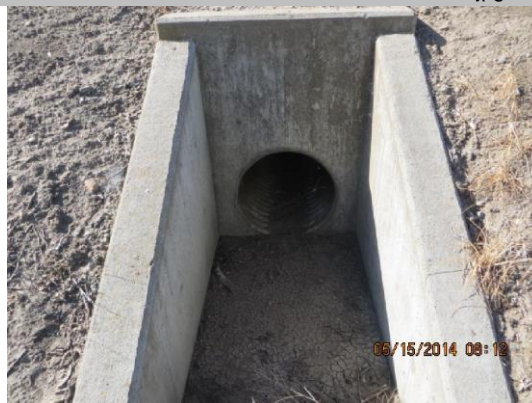
Photo 3 of 3 : UCIP_FA_2019_37840_68836.jpg

Pipe and headwall on LS toe.

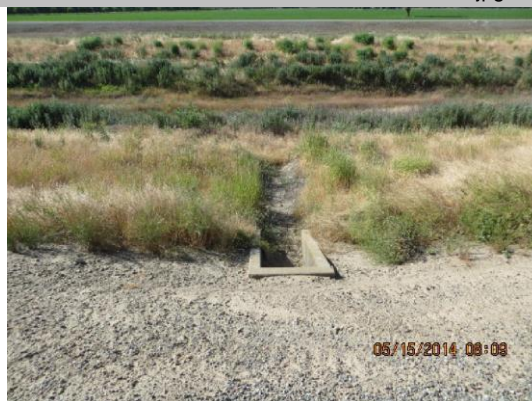
Photo 1 of 3 : UCIP_FA_2019_37839_68833.jpg

LM Start	7.35	Rating **	A/W	Issue No.	1101	
LM End	7.35	Issue Type +	Ma	Location *		
Category	Supplemental			GPS Latitude/Longitude		
				Start		End
Item	DRAFT DWR UCIP LMA Responsibility			38.065036 °		38.065036 °
				-121.250691 °		-121.250691 °
DWR ID	23565					
Comment Code						
Inspector Comment						
DS_ID:23565 FS_ID:37839 EP_NO: N/A Repair Type: No Action Needed Crossing Status: Found UCIP Comments: FIELD_STRUCT_DESC: 24-inch corrugated metal drainage pipe through the levee, 7 feet below the crown. Concrete U-shaped headwalls on both ends. Flap gate on the waterside (WS) end. Cobble grouted spillway across the berm. Cobble grouted apron on the landside (LS) end. [Additional Reference(s): DWR Levee Log, 1987. USACE San Joaquin O&M Manual 612.2, 1967, (HLM 7.75)]. FS Date: 5/15/2014

Pipe, headwall, flapgate, and grouted spillway on WS toe.

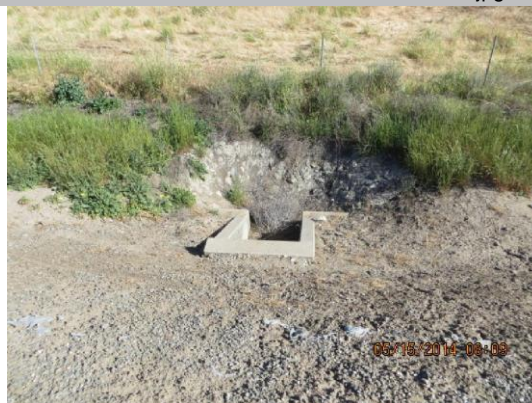
Photo 2 of 3 : UCIP_FA_2019_37839_68832.jpg

Pipe and headwall on LS toe.

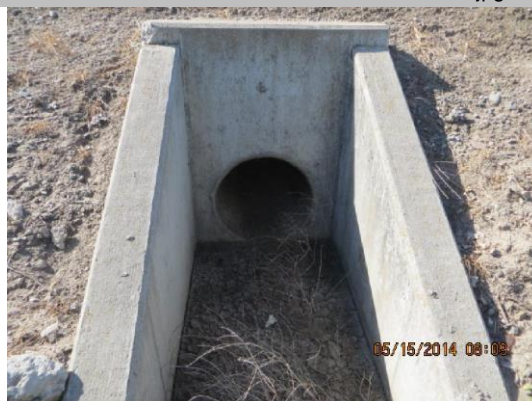
Photo 3 of 3 : UCIP_FA_2019_37839_68831.jpg

Pipe and headwall on LS toe.

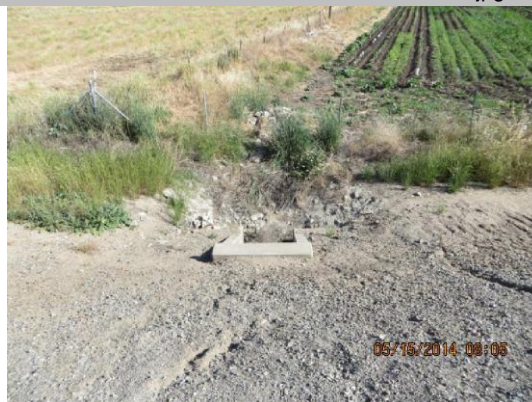
Photo 1 of 3 : UCIP_FA_2019_37838_68828.jpg

LM Start	7.36	Rating **	A/W	Issue No.	1102
LM End	7.36	Issue Type +	Ma	Location *	
Category	Supplemental			GPS Latitude/Longitude	
				Start	End
Item	DRAFT DWR UCIP LMA Responsibility			38.065066 °	38.065066 °
				-121.250523 °	-121.250523 °
DWR ID	23566				
Comment Code					
Inspector Comment					
DS_ID:23566					
FS_ID:37838					
EP_NO: N/A					
Repair Type: No Action Needed					
Crossing Status: Found					
UCIP Comments:					
FIELD_STRUCT_DESC: 24-inch corrugated metal storm drainage pipe through the levee, 7 feet below the crown. Concrete U-shaped headwalls on both ends. Flap gate on the waterside (WS) end. Cobble grouted spillway across the berm. Cobble grouted apron on the landside (LS) end. [Additional Reference(s): DWR Levee Log, 1987. USACE San Joaquin O&M Manual 612.2, 1967, (HLM 7.76) and 612 (addendum), February 1999, (HLM 7.78) (Station 410+54)].					
FS Date: 5/15/2014

Pipe and headwall on LS toe.

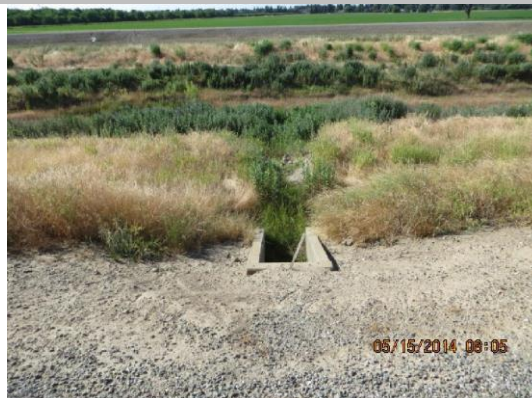
Photo 2 of 3 : UCIP_FA_2019_37838_68827.jpg

Pipe, headwall, flapgate, and grouted spillway on WS toe.

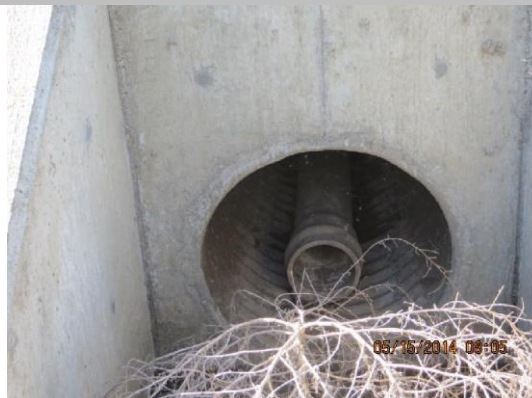
Photo 3 of 3 : UCIP_FA_2019_37838_68826.jpg

Pipe and headwall on LS toe. Irrigation pipe laying inside pipe.

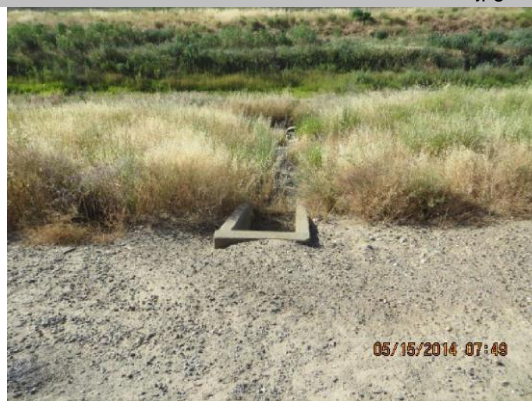
Photo 1 of 3 : UCIP_FA_2019_37837_68823.jpg

Pipe, flapgate, headwall, and grouted spillway on WS toe.

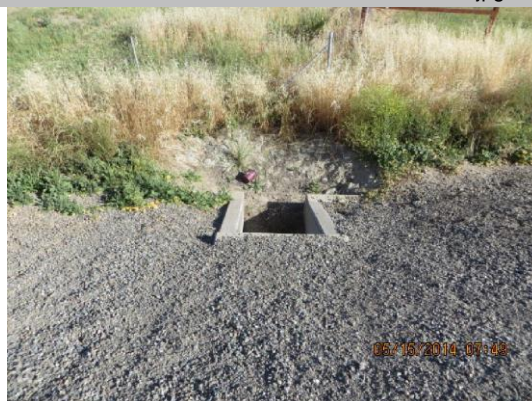
Photo 2 of 3 : UCIP_FA_2019_37837_68822.jpg

Pipe and headwall on LS toe.

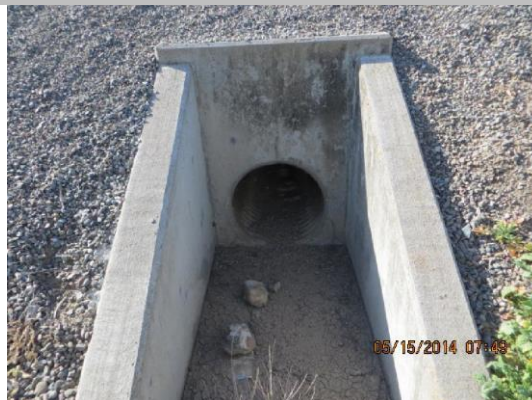
Photo 3 of 3 : UCIP_FA_2019_37837_68821.jpg

Pipe and headwall on LS toe.

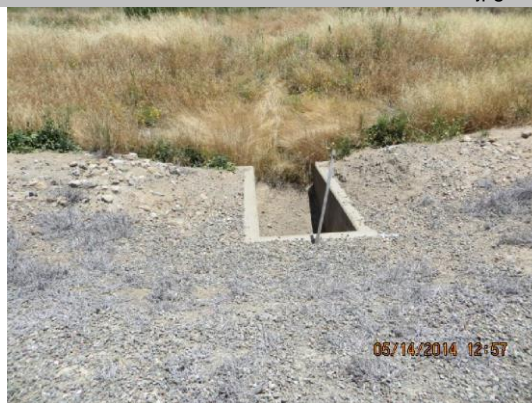
Photo 1 of 3 : UCIP_FA_2019_37835_68818.jpg

Pipe, flapgate, and headwall at WS toe.

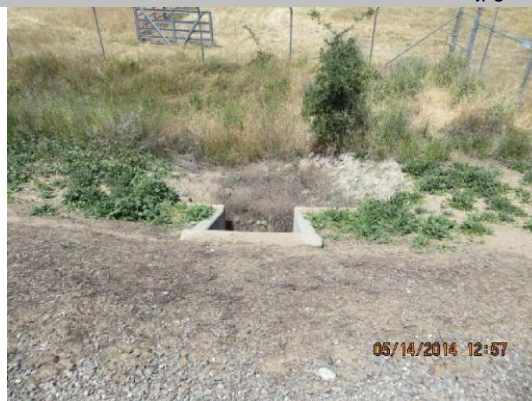
Photo 2 of 3 : UCIP_FA_2019_37835_68817.jpg

Pipe and headwall at LS toe.

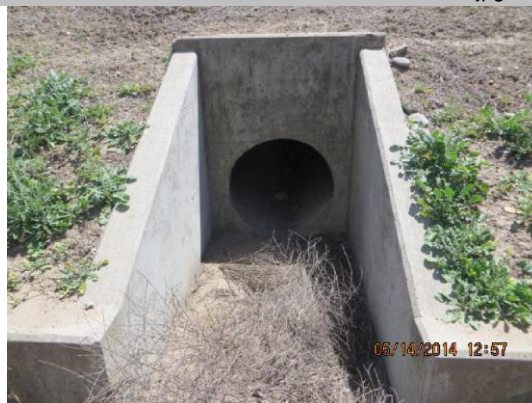
Photo 3 of 3 : UCIP_FA_2019_37835_68816.jpg

Pipe and headwall at LS toe.

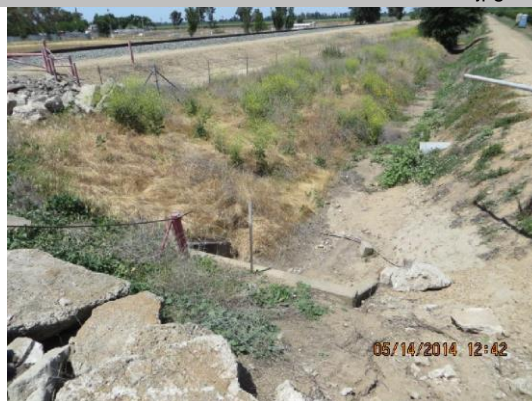
Photo 1 of 3 : UCIP_FA_2019_37832_68813.jpg

Pipe and headwall on LS toe.

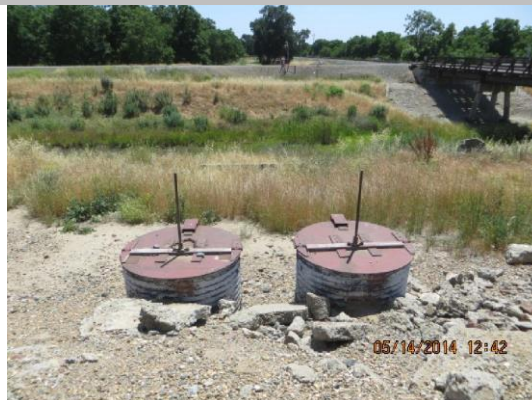
Photo 2 of 3 : UCIP_FA_2019_37832_68812.jpg

Slidegate in 48-inch CMP riser on WS slope.

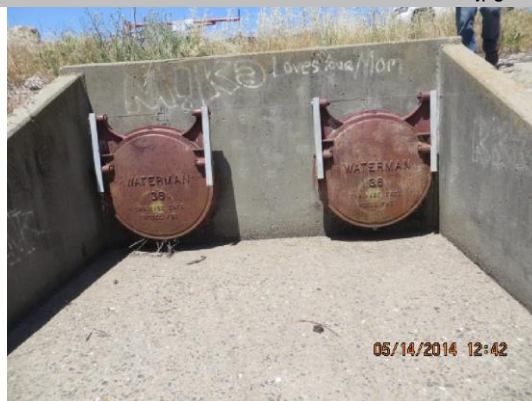
Photo 3 of 3 : UCIP_FA_2019_37832_68811.jpg

Pipe, headwall, and flapgate on WS toe.

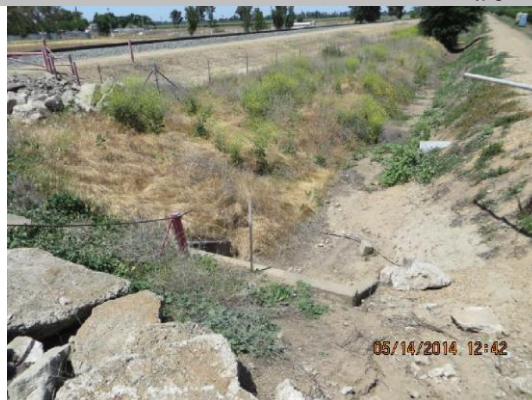
Photo 1 of 3 : UCIP_FA_2019_37831_68808.jpg

Pipe and headwall on LS toe.

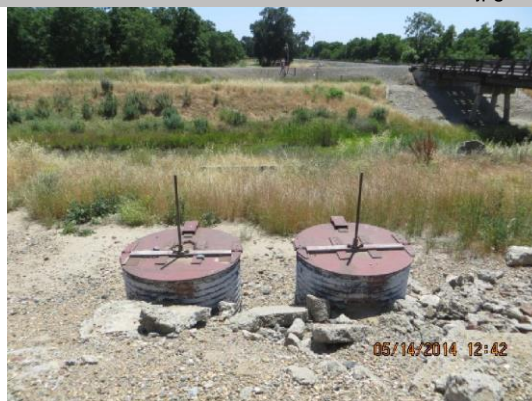
Photo 2 of 3 : UCIP_FA_2019_37831_68807.jpg

Slide gate in 48-inch CMP riser on WS slope.

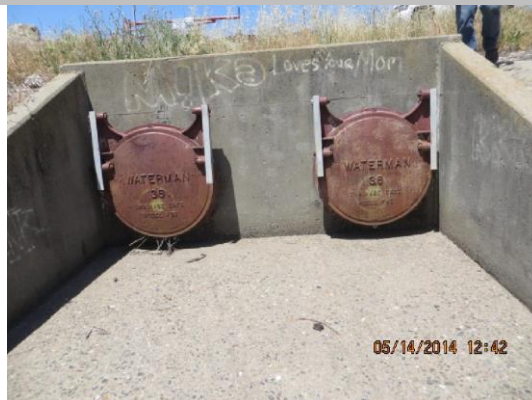
Photo 3 of 3 : UCIP_FA_2019_37831_68806.jpg

Pipe, flapgate, and headwall on WS slope.

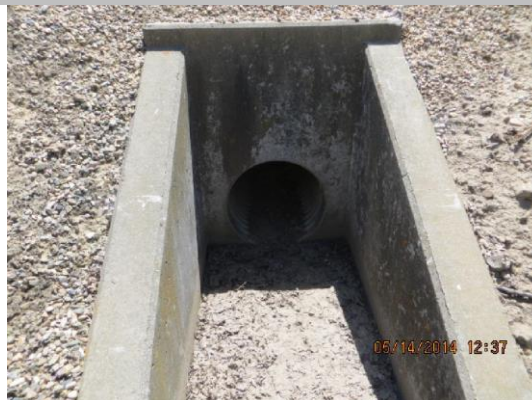
Photo 2 of 3 : UCIP_FA_2019_37830_68803.jpg

Pipe and headwall on LS toe.

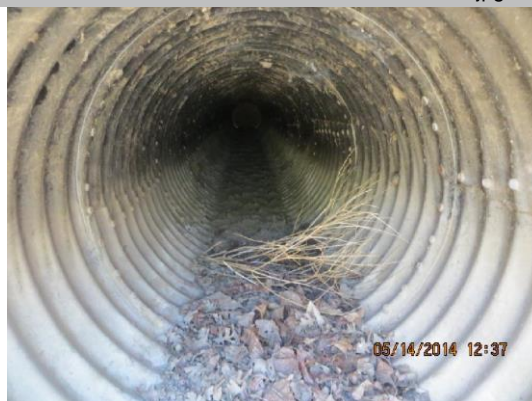
Photo 3 of 3 : UCIP_FA_2019_37830_68802.jpg

Inside pipe on LS toe.

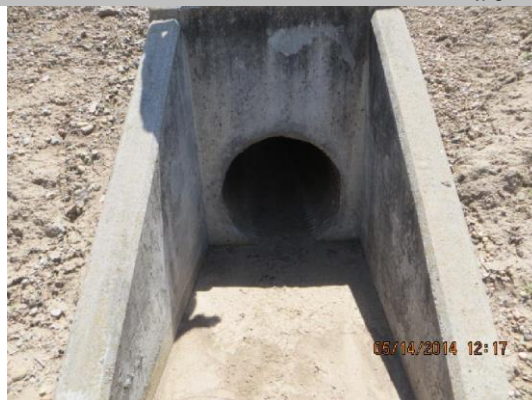
Photo 1 of 3 : UCIP_FA_2019_37826_68796.jpg

Pipe and headwall on LS toe.

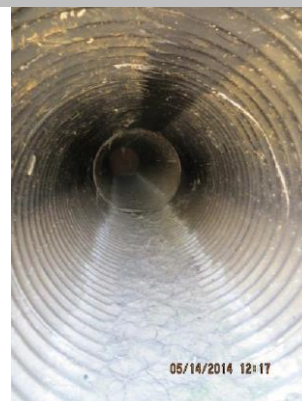
Photo 2 of 3 : UCIP_FA_2019_37826_68795.jpg

Comment Code					
Inspector Comment					
DS_ID:23572					
FS_ID:37826					
EP_NO: N/A					
Repair Type: Non-Urgent					
Crossing Status: Found					
UCIP Comments: A gap at the joint between pipe sections was noted inside pipe at LS toe. This may indicate a need for further maintenance.					
FIELD_STRUCT_DESC: 36-inch corrugated metal drainage pipe through the levee, 7 feet below the crown. Flap gate on the waterside (WS) end. Concrete U-shaped headwalls on both ends. Cobble grouted spillway across the berm. Cobble grouted apron on the landside (LS) end. [Additional Reference(s): DWR Levee Log, 1987. USACE San Joaquin O&M Manual 612.2, 1967, (HLM 8.77)].					
FS Date: 5/14/2014

Inside pipe at LS toe. Note gap at joint between pipes.

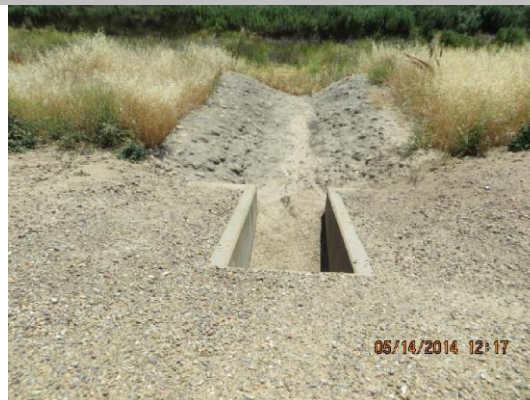
Photo 3 of 3 : UCIP_FA_2019_37826_68794.jpg

Headwall, pipe, flapgate, and grouted spillway on WS toe.

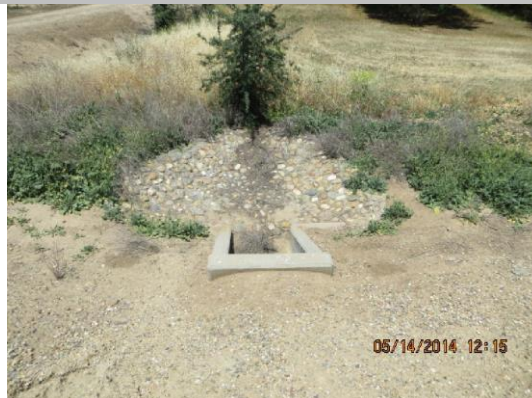
Photo 1 of 3 : UCIP_FA_2019_37825_68791.jpg

Pipe and headwall on LS toe.

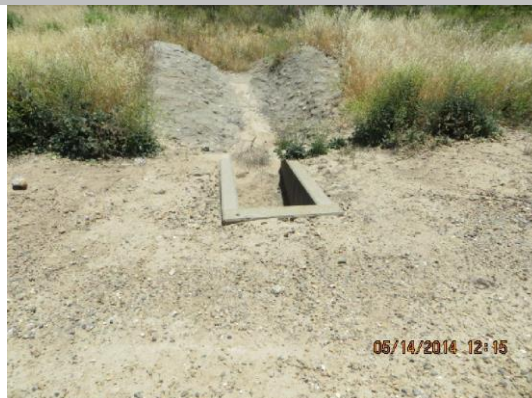
Photo 2 of 3 : UCIP_FA_2019_37825_68790.jpg

Pipe, headwall, flapgate, and grouted spillway on WS toe.

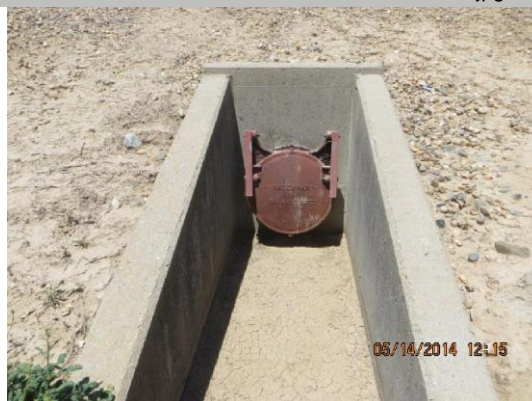
Photo 3 of 3 : UCIP_FA_2019_37825_68789.jpg

Pipe, headwall, and flapgate on WS toe.

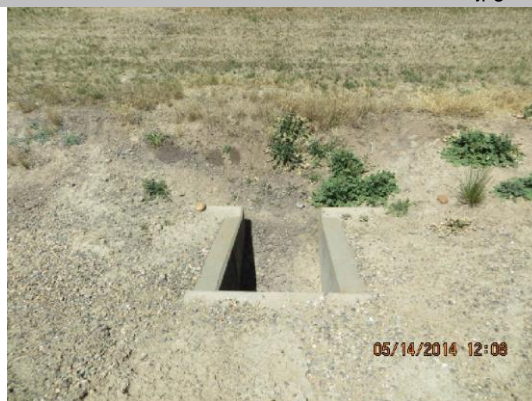
Photo 1 of 3 : UCIP_FA_2019_37818_68761.jpg

Pipe and headwall on LS toe.

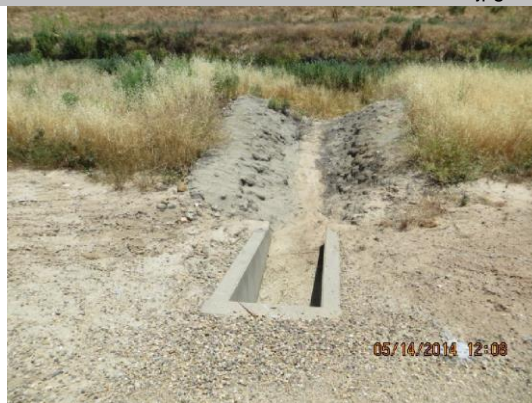
Photo 2 of 3 : UCIP_FA_2019_37818_68760.jpg

Pipe, flapgate, headwall, and grouted spillway on WS toe.

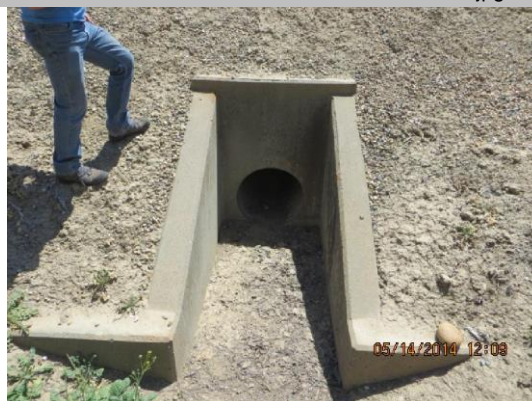
Photo 3 of 3 : UCIP_FA_2019_37818_68759.jpg

Pipe and headwall on LS toe.

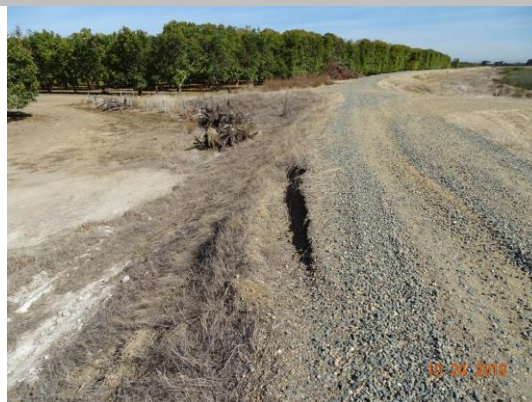
Photo 1 of 1 : FA_2019_NA0017_151_191_20191117_00348.jpg

LM Start	8.70	Rating **	M	Issue No.	191
LM End	8.70	Issue Type +	Ma	Location *	LS
Category	Earthen Levee			GPS Latitude/Longitude	
				Start	End
Item	Slope Stability			38.070083 °	38.070083 °
				-121.227359 °	-121.227359 °
DWR ID	DWR_NA0017_07_f_2019_191				
Comment Code					
S3 : Repair the levee slope damaged by vehicle traffic and prevent access where possible.					
Inspector Comment					
Tire rut on landside shoulder caused by vehicular traffic accessing bridge crossing. LMA will fill and compact deficit.

View of tire rut on crown surface. Fall 2019

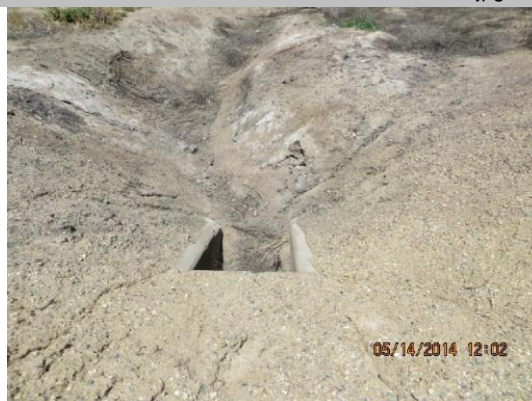
Photo 1 of 3 : UCIP_FA_2019_40206_68756.jpg

LM Start	8.73	Rating **	A/W	Issue No.	1111
LM End	8.73	Issue Type +	Ma	Location *	
Category	Supplemental			GPS Latitude/Longitude	
				Start	End
Item	DRAFT DWR UCIP LMA Responsibility			38.070171 °	38.070171 °
				-121.226915 °	-121.226915 °
DWR ID	23576				
Comment Code					
Inspector Comment					
DS_ID:23576 FS_ID:40206 EP_NO: N/A Repair Type: No Action Needed Crossing Status: Found UCIP Comments: Skunks in pipe. FIELD_STRUCT_DESC: 24-inch corrugated metal storm drainage pipe through the levee, 6.5 feet below the crown. Flap gate on the waterside (WS) end. Concrete U-shaped headwalls on both ends. Cobble grouted spillway across the berm. Cobble grouted apron on the landside (LS) end. [Additional Reference(s): DWR Levee Log, 1987. USACE San Joaquin O&M Manual 612.2, 1967, (HLM 9.17) and 612 (addendum), February 1999, (HLM 9.17) (Station 484+30)]. FS Date: 5/14/2014

Pipe and headwall on LS toe.

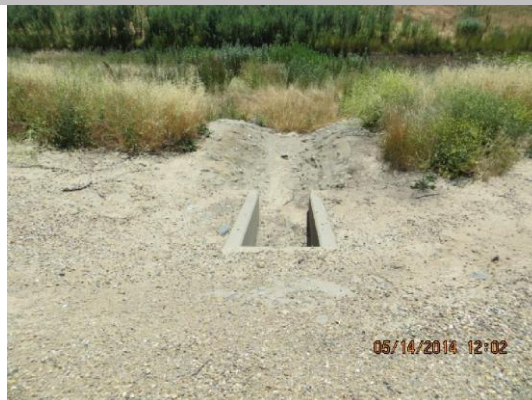
Photo 2 of 3 : UCIP_FA_2019_40206_68755.jpg

Pipe, flapgate, and headwall on WS toe.

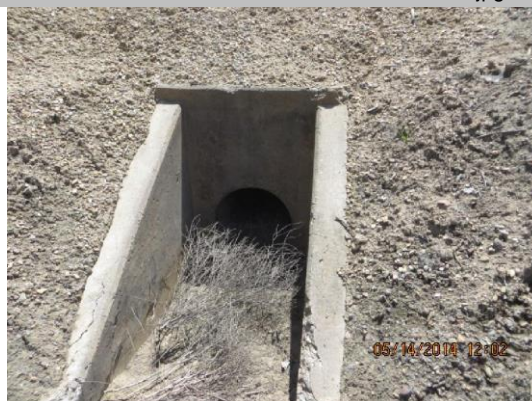
Photo 3 of 3 : UCIP_FA_2019_40206_68754.jpg

Item	DRAFT DWR UCIP LMA Responsibility			38.070171 °		38.070171 °
				-121.226915 °		-121.226915 °
DWR ID	23576					
Comment Code						
Inspector Comment						
DS_ID:23576						
FS_ID:40206						
EP_NO: N/A						
Repair Type: No Action Needed						
Crossing Status: Found						
UCIP Comments: Skunks in pipe.						
FIELD_STRUCT_DESC: 24-inch corrugated metal storm drainage pipe through the levee, 6.5 feet below the crown. Flap gate on the waterside (WS) end. Concrete U-shaped headwalls on both ends. Cobble grouted spillway across the berm. Cobble grouted apron on the landside (LS) end. [Additional Reference(s): DWR Levee Log, 1987. USACE San Joaquin O&M Manual 612.2, 1967, (HLM 9.17) and 612 (addendum), February 1999, (HLM 9.17) (Station 484+30)].						
FS Date: 5/14/2014

Pipe and headwall on LS toe.

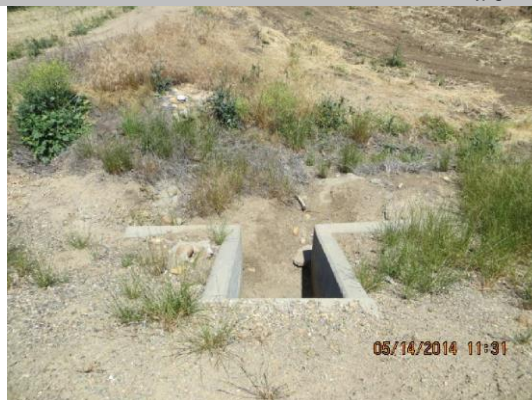
Photo 1 of 3 : UCIP_FA_2019_42951_68751.jpg

LM Start	8.96	Rating **	A/W	Issue No.	1112
LM End	8.96	Issue Type +	Ma	Location *	
Category	Supplemental			GPS Latitude/Longitude	
				Start	End
Item	DRAFT DWR UCIP LMA Responsibility			38.070330 °	38.070330 °
				-121.222680 °	-121.222680 °
DWR ID	23578				
Comment Code					
Inspector Comment					
DS_ID:23578					
FS_ID:42951					
EP_NO: N/A					
Repair Type: No Action Needed					
Crossing Status: Found					
UCIP Comments:					
FIELD_STRUCT_DESC: 24-inch corrugated metal drainage pipe through the levee, 8 feet below the crown. Flap gate on the waterside (WS) end. Concrete U-shaped headwall on both ends. Cobble grouted spillway across the berm. Cobble grouted apron on the landside (LS) end. [Additional Reference(s): DWR Levee Log, 1987. USACE San Joaquin O&M Manual 612.2, 1967, (HLM 9.41) and 612 (addendum), February 1999, (HLM 9.37) (Station 494+50)].					
FS Date: 5/14/2014

Pipe and headwall on LS toe.

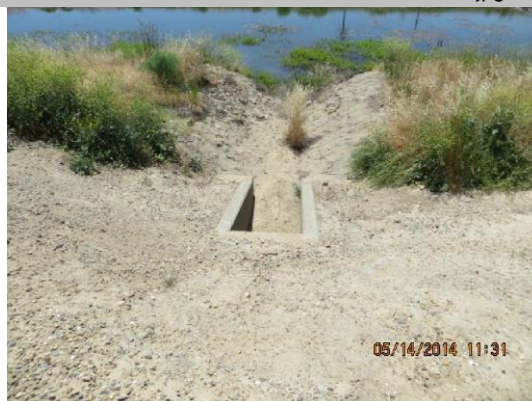
Photo 2 of 3 : UCIP_FA_2019_42951_68750.jpg

Headwall, pipe, flapgate, and grouted spillway on WS toe.

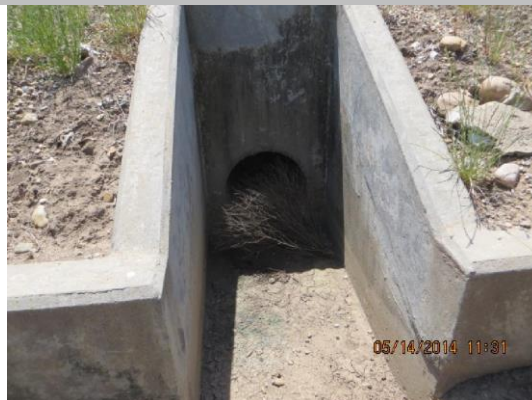
Photo 3 of 3 : UCIP_FA_2019_42951_68749.jpg

Pipe and headwall on LS toe.

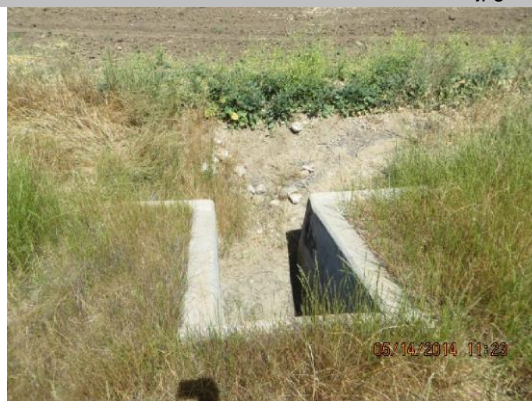
Photo 1 of 3 : UCIP_FA_2019_37813_68747.jpg

LM Start	9.11	Rating **	A/W	Issue No.	1113
LM End	9.11	Issue Type +	Ma	Location *	
Category	Supplemental			GPS Latitude/Longitude	
				Start	End
Item	DRAFT DWR UCIP LMA Responsibility			38.070367°	38.070367°
				-121.219932°	-121.219932°
DWR ID	23580				
Comment Code					
Inspector Comment					
DS_ID:23580 FS_ID:37813 EP_NO: N/A Repair Type: No Action Needed Crossing Status: Found UCIP Comments: FIELD_STRUCT_DESC: 24-inch corrugated metal storm drainage pipe through the levee, 6.5 feet below the crown. Flap gate on the waterside (WS) end. Concrete U-shaped headwall on both ends. Cobble grouted spillway and apron. [Additional Reference(s): DWR Levee Log, 1987. USACE San Joaquin O&M Manual 612.2, 1967, (HLM 9.56) and 612 (addendum), February 1999, (HLM 9.56) (Station 504+71)]. FS Date: 5/14/2014

Headwall and pipe at LS toe.

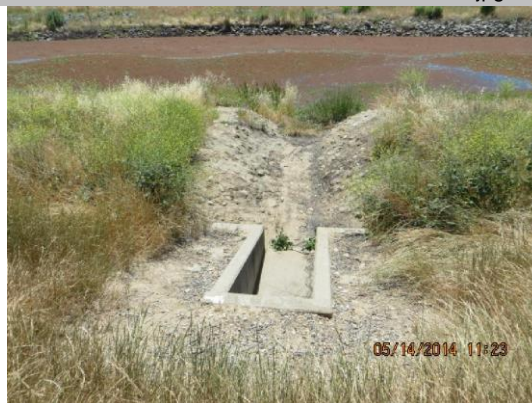
Photo 2 of 3 : UCIP_FA_2019_37813_68746.jpg

Headwall, pipe, flapgate, and grouted spillway on WS toe.

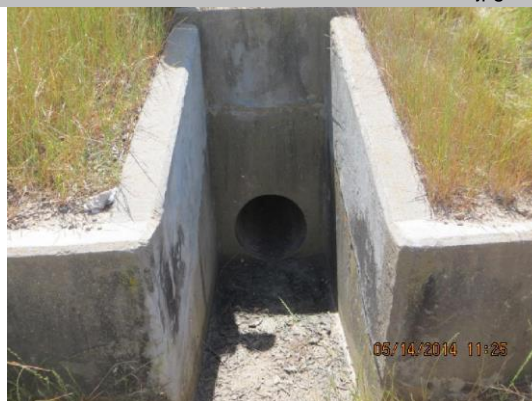
Photo 3 of 3 : UCIP_FA_2019_37813_68745.jpg

LM Start	9.11	Rating **	A/W	Issue No.	1113 (cont)	
LM End	9.11	Issue Type +	Ma	Location *		
Category	Supplemental			GPS Latitude/Longitude		
				Start	End	
Item	DRAFT DWR UCIP LMA Responsibility			38.070367°	38.070367°	
				-121.219932°	-121.219932°	
DWR ID	23580					
Comment Code						
Inspector Comment						
DS_ID:23580						
FS_ID:37813						
EP_NO: N/A						
Repair Type: No Action Needed						
Crossing Status: Found						
UCIP Comments:						
FIELD_STRUCT_DESC: 24-inch corrugated metal storm drainage pipe through the levee, 6.5 feet below the crown. Flap gate on the waterside (WS) end. Concrete U-shaped headwall on both ends. Cobble grouted spillway and apron. [Additional Reference(s): DWR Levee Log, 1987. USACE San Joaquin O&M Manual 612.2, 1967, (HLM 9.56) and 612 (addendum), February 1999, (HLM 9.56) (Station 504+71)].						
FS Date: 5/14/2014

Headwall and pipe at LS toe.
