**Flood Control Project Maintenance
Levee Inspections**

Maintenance Issue Types Only, Levee Inspection Report By Mile - Fall 2019

San Joaquin County Flood Control and Water Conservation District

Waterway	Bank	Unit Miles	Inspection Start/End	Inspector
Unit No. 01 Littlejohn Creek	Left	2.59	11/14/2019 11/14/2019	Alberto De Leon

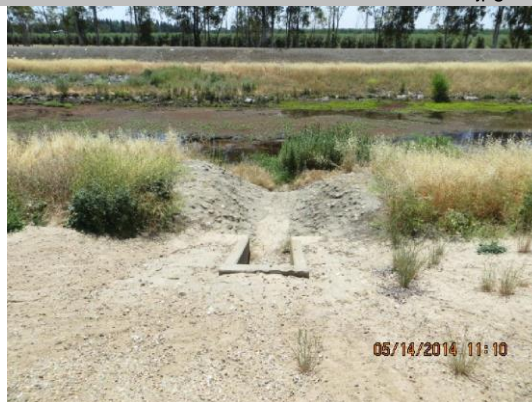
Photo 1 of 3 : UCIP_FA_2019_37810_68742.jpg

LM Start	9.45	Rating **	A/W	Issue No.	1114	
LM End	9.45	Issue Type +	Ma	Location *		
Category	Supplemental			GPS Latitude/Longitude		
				Start		End
Item	DRAFT DWR UCIP LMA Responsibility			38.073368 °		38.073368 °
				-121.215349 °		-121.215349 °
DWR ID	23582					
Comment Code						
Inspector Comment						
DS_ID:23582 FS_ID:37810 EP_NO: N/A Repair Type: No Action Needed Crossing Status: Found UCIP Comments: FIELD_STRUCT_DESC: 24-inch corrugated metal drainage pipe through the levee, 7.5 feet below the crown. Flap gate on the waterside (WS) end. Concrete U-shaped headwalls on both ends. Cobble grouted spillway across the berm. Cobble grouted apron on the WS end. [Additional Reference(s): DWR Levee Log, 1987. USACE San Joaquin O&M Manual 612.2, 1967, (HLM 9.91)]. FS Date: 5/14/2014

Headwall and flapgate on WS toe.

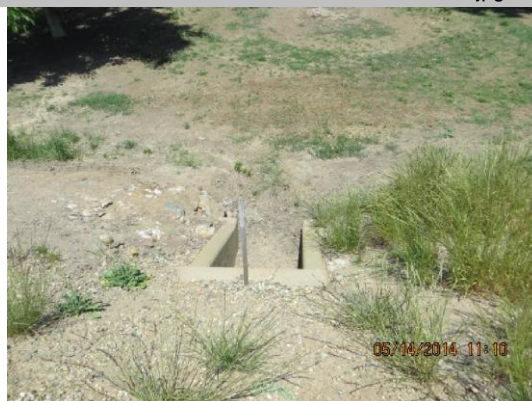
Photo 2 of 3 : UCIP_FA_2019_37810_68741.jpg

LM Start	9.45	Rating **	A/W	Issue No.	1114 (cont)	
LM End	9.45	Issue Type +	Ma	Location *		
Category	Supplemental			GPS Latitude/Longitude		
				Start	End	
Item	DRAFT DWR UCIP LMA Responsibility			38.073368 °	38.073368 °	
				-121.215349 °	-121.215349 °	
DWR ID	23582					
Comment Code						
Inspector Comment						
DS_ID:23582 FS_ID:37810 EP_NO: N/A Repair Type: No Action Needed Crossing Status: Found UCIP Comments: FIELD_STRUCT_DESC: 24-inch corrugated metal drainage pipe through the levee, 7.5 feet below the crown. Flap gate on the waterside (WS) end. Concrete U-shaped headwalls on both ends. Cobble grouted spillway across the berm. Cobble grouted apron on the WS end. [Additional Reference(s): DWR Levee Log, 1987. USACE San Joaquin O&M Manual 612.2, 1967, (HLM 9.91)]. FS Date: 5/14/2014

Pipe and headwall on LS toe.

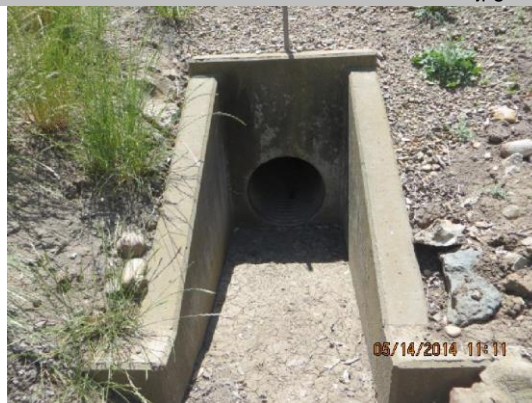
Photo 3 of 3 : UCIP_FA_2019_37810_68740.jpg

Pipe and headwall on LS toe.

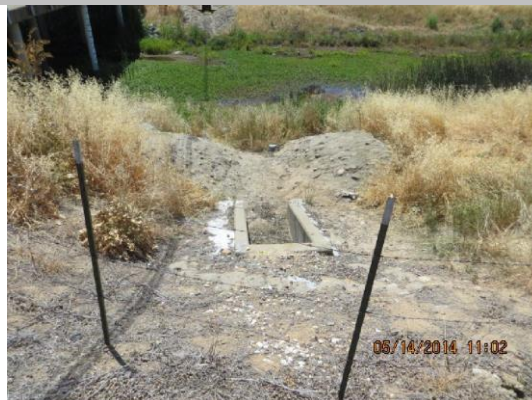
Photo 2 of 3 : UCIP_FA_2019_37809_68737.jpg

Headwall, pipe, and flapgate on WS toe.

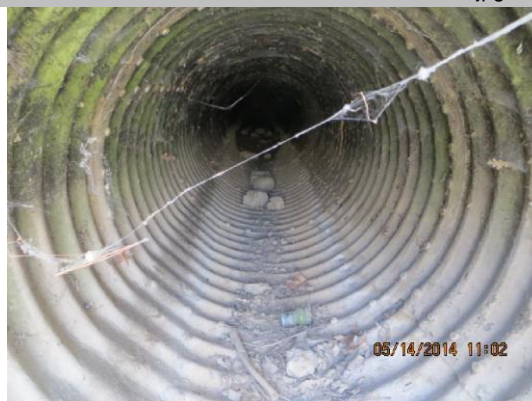
Photo 3 of 3 : UCIP_FA_2019_37809_68736.jpg

Item	DRAFT DWR UCIP LMA Responsibility			38.074113 °		38.074113 °
				-121.212224 °		-121.212224 °
DWR ID	23583					
Comment Code						
Inspector Comment						
DS_ID:23583						
FS_ID:37809						
EP_NO: N/A						
Repair Type: No Action Needed						
Crossing Status: Found						
UCIP Comments:						
FIELD_STRUCT_DESC: 24-inch corrugated metal storm drainage pipe through the levee, 10 feet below the crown. Flap gate on the waterside (WS) end. Concrete U-shaped headwalls on both ends. Cobble grouted spillway across the berm. Cobble grouted apron on the landside (LS) end. [Additional Reference(s): DWR Levee Log, 1987. USACE San Joaquin O&M Manual 612.2, 1967, (HLM 10.09) and 612 (addendum), February 1999, (HLM 9.94) (Station 524+90)].						
FS Date: 5/14/2014

Inside pipe at LS toe.

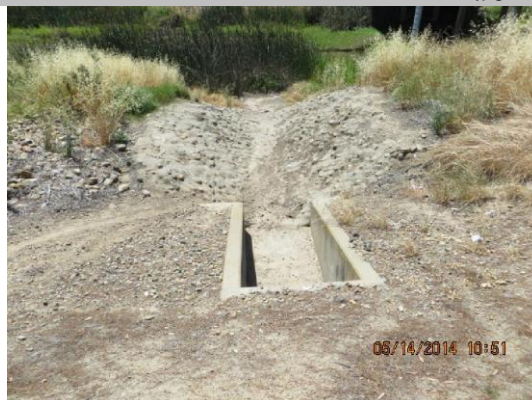
Photo 1 of 3 : UCIP_FA_2019_37807_68732.jpg

LM Start	9.65	Rating **	A/W	Issue No.	1116
LM End	9.65	Issue Type +	Ma	Location *	
Category	Supplemental			GPS Latitude/Longitude	
				Start	End
Item	DRAFT DWR UCIP LMA Responsibility			38.074201 °	38.074201 °
				-121.211920 °	-121.211920 °
DWR ID	23584				
Comment Code					
Inspector Comment					
DS_ID:23584 FS_ID:37807 EP_NO: N/A Repair Type: No Action Needed Crossing Status: Found UCIP Comments: FIELD_STRUCT_DESC: 36-inch corrugated metal drainage pipe through the levee, 6 feet below the crown. Flap gate on the waterside (WS) end. Concrete U-shaped headwalls on both ends. Cobble grouted spillway across the berm. Cobble grouted apron on the landside (LS) end. [Additional Reference(s): DWR Levee Log, 1987. USACE San Joaquin O&M Manual 612.2, 1967, (HLM 10.11)]. FS Date: 5/14/2014

Headwall, pipe, flapgate, and grouted spillway on WS toe.

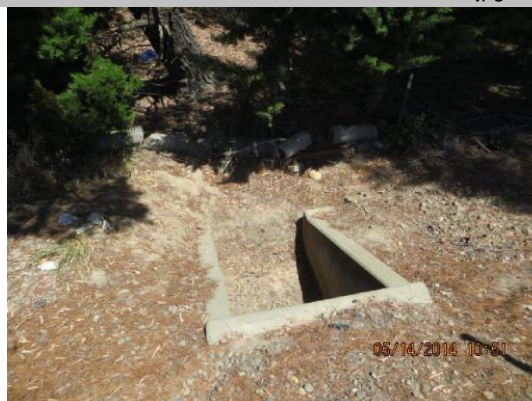
Photo 2 of 3 : UCIP_FA_2019_37807_68731.jpg

LM Start	9.65	Rating **	A/W	Issue No.	1116 (cont)	
LM End	9.65	Issue Type +	Ma	Location *		
Category	Supplemental			GPS Latitude/Longitude		
				Start		End
Item	DRAFT DWR UCIP LMA Responsibility			38.074201 °		38.074201 °
				-121.211920 °		-121.211920 °
DWR ID	23584					
Comment Code						
Inspector Comment						
DS_ID:23584 FS_ID:37807 EP_NO: N/A Repair Type: No Action Needed Crossing Status: Found UCIP Comments: FIELD_STRUCT_DESC: 36-inch corrugated metal drainage pipe through the levee, 6 feet below the crown. Flap gate on the waterside (WS) end. Concrete U-shaped headwalls on both ends. Cobble grouted spillway across the berm. Cobble grouted apron on the landside (LS) end. [Additional Reference(s): DWR Levee Log, 1987. USACE San Joaquin O&M Manual 612.2, 1967, (HLM 10.11)]. FS Date: 5/14/2014

Pipe and headwall on LS toe.

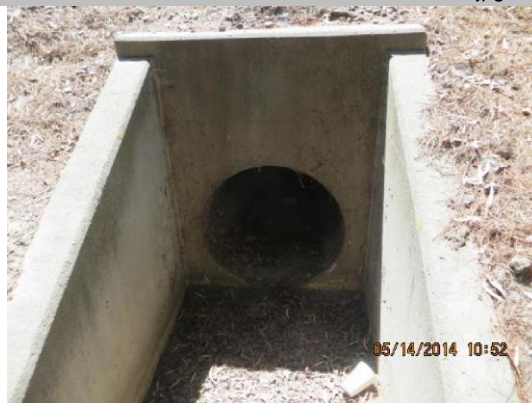
Photo 3 of 3 : UCIP_FA_2019_37807_68730.jpg

Pipe and headwall on LS toe.

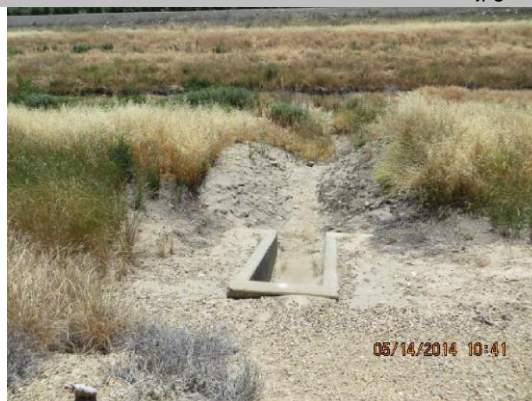
Photo 1 of 3 : UCIP_FA_2019_41804_68727.jpg

LM Start	9.98	Rating **	M	Issue No.	1117
LM End	9.98	Issue Type +	Ma	Location *	
Category	Supplemental			GPS Latitude/Longitude	
				Start	End
Item	DRAFT DWR UCIP LMA Responsibility			38.077230 °	38.077230 °
				-121.208208 °	-121.208208 °
DWR ID	23585				
Comment Code					
Inspector Comment					
DS_ID:23585 FS_ID:41804 EP_NO: N/A Repair Type: Non-Urgent Crossing Status: Found UCIP Comments: Some silt buildup in pipe. FIELD_STRUCT_DESC: 24-inch corrugated metal storm drainage pipe through the levee, 7.5 feet below the crown. Flap gate on the waterside (WS) end. Concrete U-shaped headwalls on both ends. Cobble grouted spillway across the berm. [Additional Reference(s): DWR Levee Log, 1987. USACE San Joaquin O&M Manual 612.2, 1967, (HLM 10.45) and 612 (addendum), February 1999, (HLM 10.46) (Station 552+25)]. FS Date: 5/14/2014

Headwall, pipe, flapgate, and grouted spillway on WS toe.

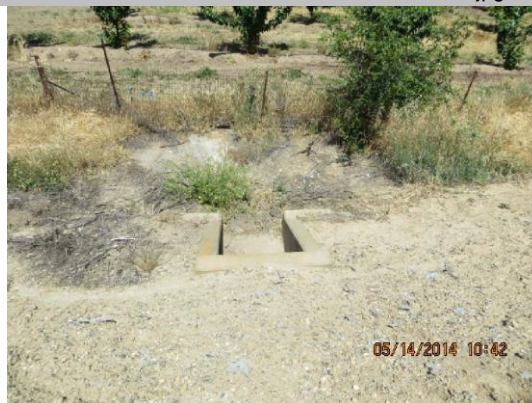
Photo 2 of 3 : UCIP_FA_2019_41804_68726.jpg

Pipe and headwall on LS toe.

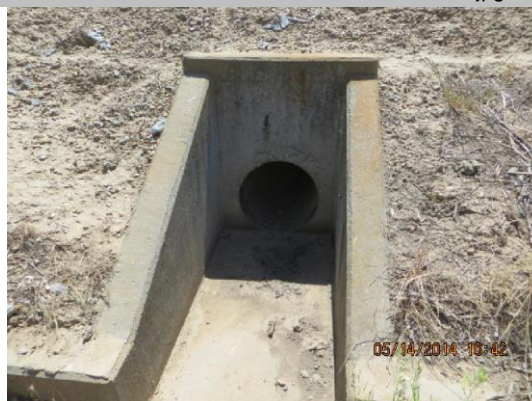
Photo 3 of 3 : UCIP_FA_2019_41804_68725.jpg

LM Start	9.98	Rating **	M	Issue No.	1117 (cont)
LM End	9.98	Issue Type +	Ma	Location *	
Category	Supplemental			GPS Latitude/Longitude	
				Start	End
Item	DRAFT DWR UCIP LMA Responsibility			38.077230 °	38.077230 °
				-121.208208 °	-121.208208 °
DWR ID	23585				
Comment Code					
Inspector Comment					
DS_ID:23585 FS_ID:41804 EP_NO: N/A Repair Type: Non-Urgent Crossing Status: Found UCIP Comments: Some silt buildup in pipe. FIELD_STRUCT_DESC: 24-inch corrugated metal storm drainage pipe through the levee, 7.5 feet below the crown. Flap gate on the waterside (WS) end. Concrete U-shaped headwalls on both ends. Cobble grouted spillway across the berm. [Additional Reference(s): DWR Levee Log, 1987. USACE San Joaquin O&M Manual 612.2, 1967, (HLM 10.45) and 612 (addendum), February 1999, (HLM 10.46) (Station 552+25)]. FS Date: 5/14/2014

Pipe and headwall on LS toe.

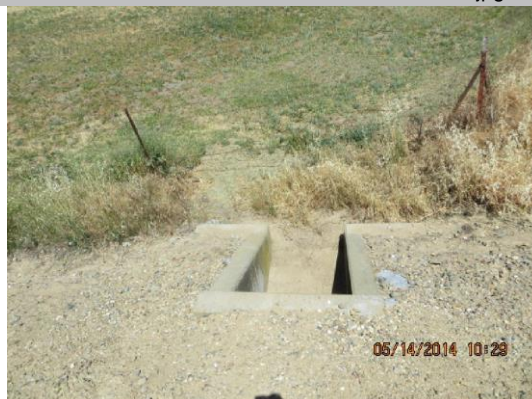
Photo 1 of 3 : UCIP_FA_2019_37803_68722.jpg

LM Start	10.15	Rating **	A/W	Issue No.	1118	
LM End	10.15	Issue Type +	Ma	Location *		
Category	Supplemental			GPS Latitude/Longitude		
				Start		End
Item	DRAFT DWR UCIP LMA Responsibility			38.078814 °		38.078814 °
				-121.205762 °		-121.205762 °
DWR ID	23586					
Comment Code						
Inspector Comment						
DS_ID:23586 FS_ID:37803 EP_NO: N/A Repair Type: No Action Needed Crossing Status: Found UCIP Comments: FIELD_STRUCT_DESC: 24-inch corrugated metal drainage pipe through the levee, 6 feet below the crown. Flap gate on the waterside (WS) end. Concrete U-shaped headwalls on both ends. Cobble grouted spillway across the berm. Cobble grouted apron on the landside (LS) end. [Additional Reference(s): USACE San Joaquin O&M Manual 612.2, 1967, (HLM 10.62)]. FS Date: 5/14/2014

Pipe and headwall on LS toe.

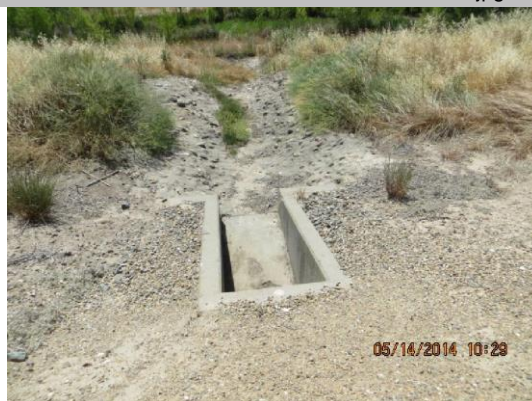
Photo 2 of 3 : UCIP_FA_2019_37803_68721.jpg

LM Start	10.15	Rating **	A/W	Issue No.	1118 (cont)	
LM End	10.15	Issue Type +	Ma	Location *		
Category	Supplemental			GPS Latitude/Longitude		
				Start		End
Item	DRAFT DWR UCIP LMA Responsibility			38.078814 °		38.078814 °
				-121.205762 °		-121.205762 °
DWR ID	23586					
Comment Code						
Inspector Comment						
DS_ID:23586						
FS_ID:37803						
EP_NO: N/A						
Repair Type: No Action Needed						
Crossing Status: Found						
UCIP Comments:						
FIELD_STRUCT_DESC: 24-inch corrugated metal drainage pipe through the levee, 6 feet below the crown. Flap gate on the waterside (WS) end. Concrete U-shaped headwalls on both ends. Cobble grouted spillway across the berm. Cobble grouted apron on the landside (LS) end. [Additional Reference(s): USACE San Joaquin O&M Manual 612.2, 1967, (HLM 10.62)].						
FS Date: 5/14/2014

Headwall, pipe, flapgate, and grouted spillway on WS toe.

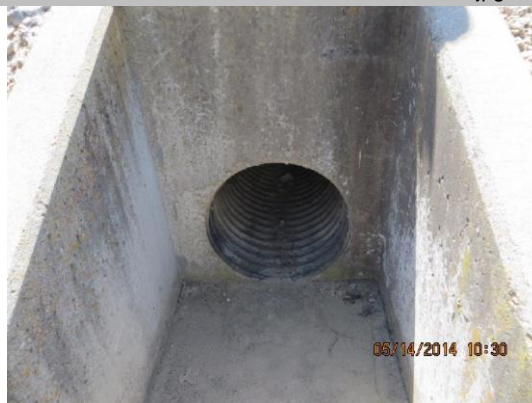
Photo 3 of 3 : UCIP_FA_2019_37803_68720.jpg

Pipe and headwall on LS toe.

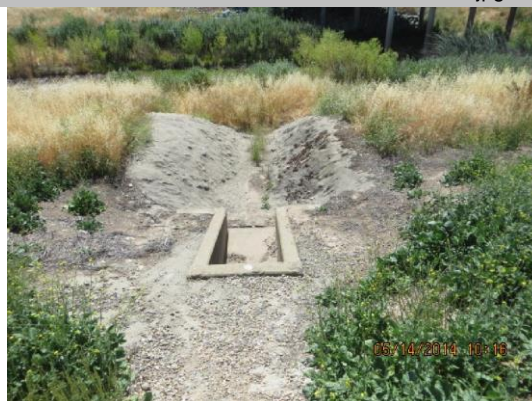
Photo 1 of 3 : UCIP_FA_2019_37786_68701.jpg

LM Start	10.43	Rating **	A/W	Issue No.	1119
LM End	10.43	Issue Type +	Ma	Location *	
Category	Supplemental			GPS Latitude/Longitude	
				Start	End
Item	DRAFT DWR UCIP LMA Responsibility			38.080050 °	38.080050 °
				-121.201087 °	-121.201087 °
DWR ID	23646				
Comment Code					
Inspector Comment					
DS_ID:23646 FS_ID:37786 EP_NO: N/A Repair Type: No Action Needed Crossing Status: Found UCIP Comments: FIELD_STRUCT_DESC: 24-inch corrugated metal storm drainage pipe through the levee, 7.5 feet below the crown. Flap gate on the waterside (WS). Concrete U-shaped headwall on both ends. [Additional Reference(s): DWR Levee Log, 1987. USACE San Joaquin O&M Manual 612.2, 1967, (HLM 10.91) and 612 (addendum), February 1999, (HLM 10.80) (Station 570+48)]. FS Date: 5/14/2014

Pipe, headwall, flapgate, and grouted spillway on WS slope.

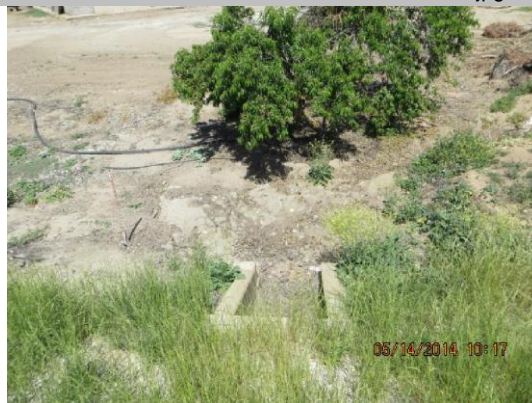
Photo 2 of 3 : UCIP_FA_2019_37786_68700.jpg

Pipe and headwall on LS toe.

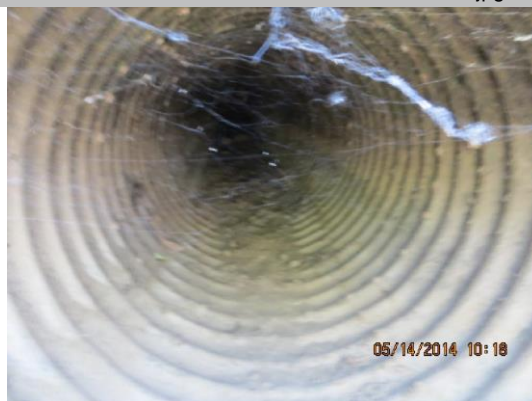
Photo 3 of 3 : UCIP_FA_2019_37786_68703.jpg

LM Start	10.43	Rating **	A/W	Issue No.	1119 (cont)	
LM End	10.43	Issue Type +	Ma	Location *		
Category	Supplemental			GPS Latitude/Longitude		
				Start	End	
Item	DRAFT DWR UCIP LMA Responsibility			38.080050 °	38.080050 °	
				-121.201087 °	-121.201087 °	
DWR ID	23646					
Comment Code						
Inspector Comment						
DS_ID:23646 FS_ID:37786 EP_NO: N/A Repair Type: No Action Needed Crossing Status: Found UCIP Comments: FIELD_STRUCT_DESC: 24-inch corrugated metal storm drainage pipe through the levee, 7.5 feet below the crown. Flap gate on the waterside (WS). Concrete U-shaped headwall on both ends. [Additional Reference(s): DWR Levee Log, 1987. USACE San Joaquin O&M Manual 612.2, 1967, (HLM 10.91) and 612 (addendum), February 1999, (HLM 10.80) (Station 570+48)]. FS Date: 5/14/2014

Inside pipe from LS toe.

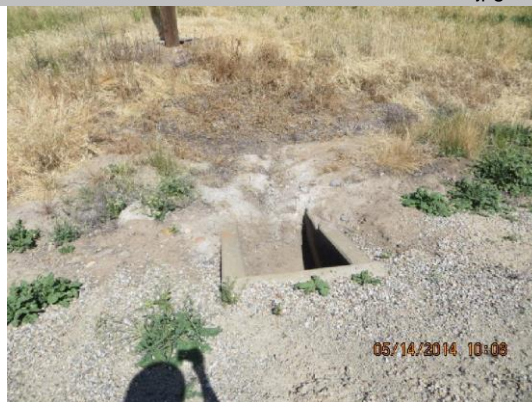
Photo 1 of 3 : UCIP_FA_2019_41805_68682.jpg

LM Start	10.65	Rating **	M	Issue No.	1120	
LM End	10.65	Issue Type +	Ma	Location *		
Category	Supplemental			GPS Latitude/Longitude		
				Start		End
Item	DRAFT DWR UCIP LMA Responsibility			38.082589 °		38.082589 °
				-121.198521 °		-121.198521 °
DWR ID	23587					
Comment Code						
Inspector Comment						
DS_ID:23587						
FS_ID:41805						
EP_NO: N/A						
Repair Type: Non-Urgent						
Crossing Status: Found						
UCIP Comments: Silt buildup in pipe at LS toe.						
FIELD_STRUCT_DESC: 24-inch corrugated metal drainage pipe through the levee, 6.5 feet below the crown. Flap gate on the waterside (WS) end. Concrete U-shaped headwall on both ends. Cobble grouted spillway across the berm. Cobble grouted apron on the WS end.						
[Additional Reference(s): DWR Levee Log, 1987. USACE San Joaquin O&M Manual 612.2, 1967, (HLM 11.13)].						
FS Date: 5/14/2014

Pipe and headwall on LS toe.

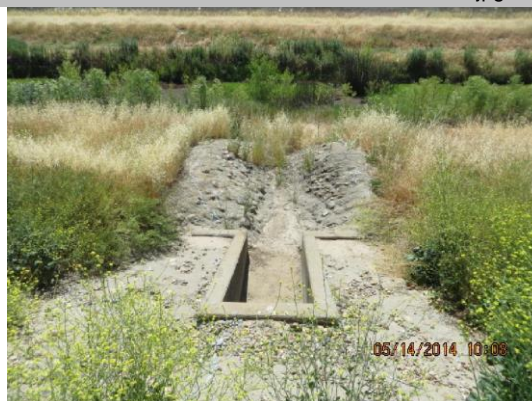
Photo 2 of 3 : UCIP_FA_2019_41805_68681.jpg

Pipe, flapgate, headwall, and grouted spillway on WS toe.

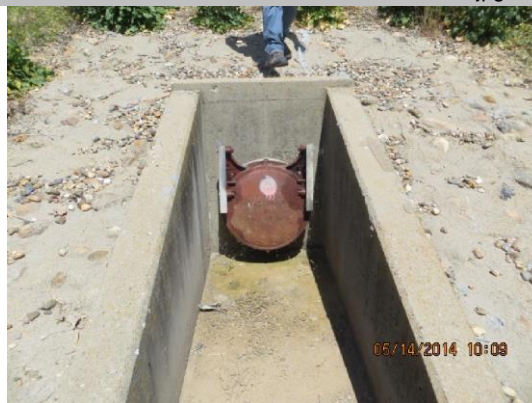
Photo 3 of 3 : UCIP_FA_2019_41805_68680.jpg

Pipe, flapgate, and headwall on WS toe.

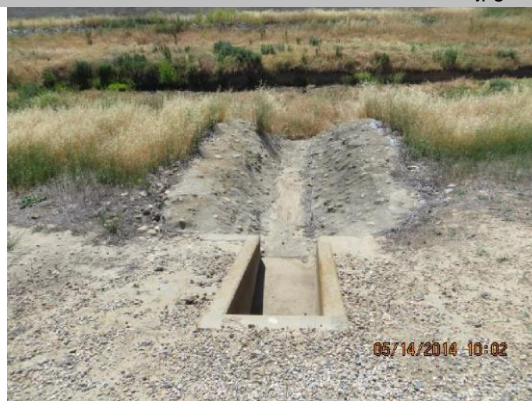
Photo 1 of 3 : UCIP_FA_2019_37779_68666.jpg

Comment Code						
Inspector Comment						
DS_ID:23588						
FS_ID:37779						
EP_NO: N/A						
Repair Type: No Action Needed						
Crossing Status: Found						
UCIP Comments:						
FIELD_STRUCT_DESC: 24-inch corrugated metal storm drainage pipe through the levee, 6.5 feet below the crown. Flap gate on the waterside (WS) end. Concrete U-shaped headwalls on both ends. Cobble grouted spillway across the berm. Cobble grouted apron on the landside (LS) end. [Additional Reference(s): DWR Levee Log, 1987. USACE San Joaquin O&M Manual 612.2, 1967, (HLM 11.30) and 612 (addendum), February 1999, (HLM 11.26) (Station 594+46)].						
FS Date: 5/14/2014

Headwall, pipe, flapgate, and grouted spillway on WS slope.

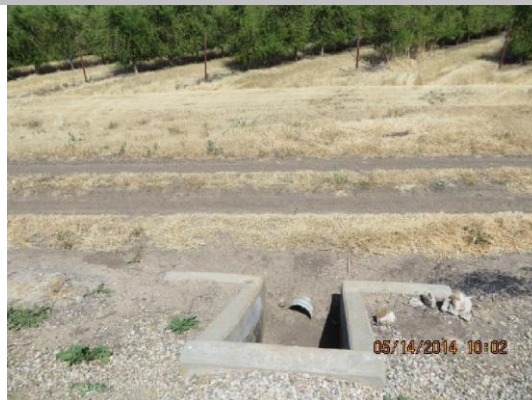
Photo 2 of 3 : UCIP_FA_2019_37779_68665.jpg

Pipe and headwall on LS toe.

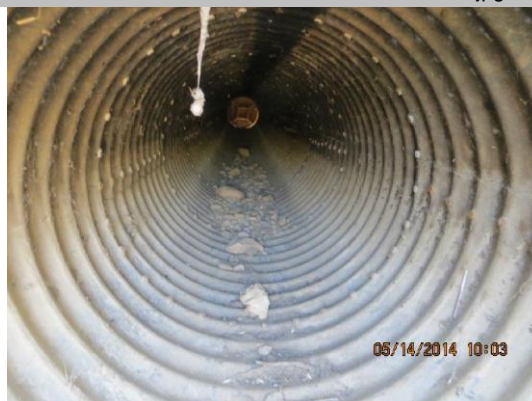
Photo 3 of 3 : UCIP_FA_2019_37779_68659.jpg

Inside pipe at LS toe.

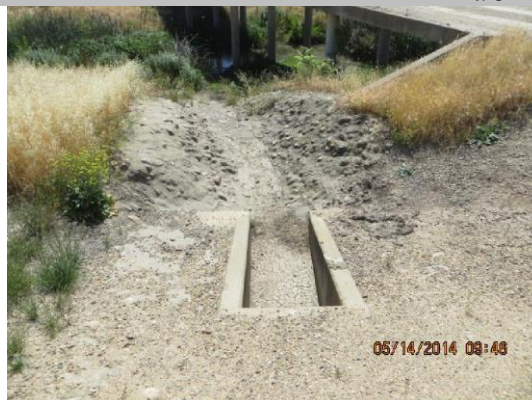
Photo 1 of 3 : UCIP_FA_2019_37773_68635.jpg

LM Start	11.27	Rating **	A/W	Issue No.	1122	
LM End	11.27	Issue Type +	Ma	Location *		
Category	Supplemental			GPS Latitude/Longitude		
				Start		End
Item	DRAFT DWR UCIP LMA Responsibility			38.087249 °		38.087249 °
				-121.189337 °		-121.189337 °
DWR ID	23590					
Comment Code						
Inspector Comment						
DS_ID:23590 FS_ID:37773 EP_NO: N/A Repair Type: No Action Needed Crossing Status: Found UCIP Comments: FIELD_STRUCT_DESC: 24-inch corrugated metal drainage pipe through the levee, 7.5 feet below the crown. Flap gate on the waterside (WS) end. Concrete U-shaped headwalls on both ends. Cobble grouted spillway across the berm. Cobble grouted apron on the landside (LS) end. [Additional Reference(s): DWR Levee Log, 1987. USACE San Joaquin O&M Manual 612.2, 1967, (HLM 11.78)]. FS Date: 5/14/2014

Headwall, pipe, flapgate, and grouted spillway on WS slope.

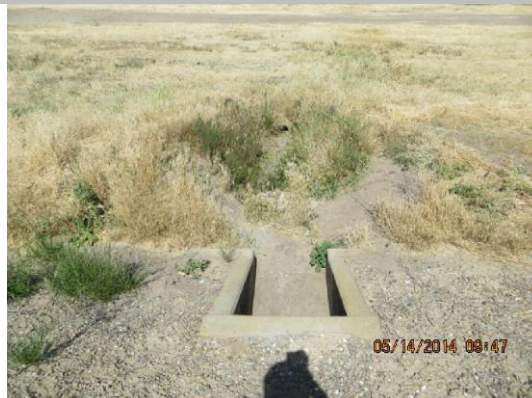
Photo 2 of 3 : UCIP_FA_2019_37773_68634.jpg

Pipe and headwall on LS toe.

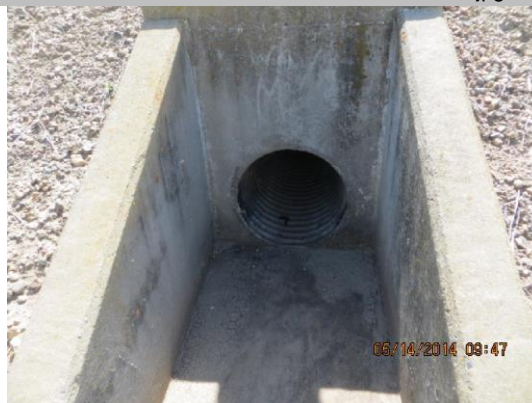
Photo 3 of 3 : UCIP_FA_2019_37773_68633.jpg

Pipe and headwall on LS toe.

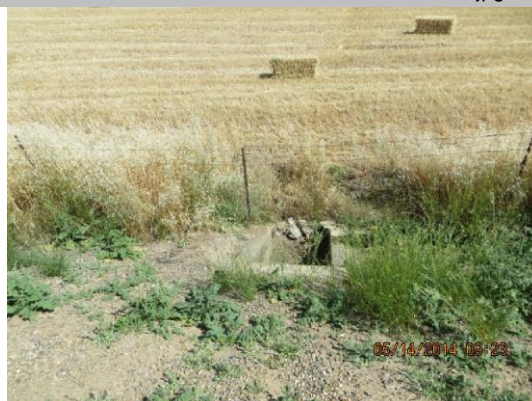
Photo 1 of 3 : UCIP_FA_2019_37753_68594.jpg

LM Start	11.79	Rating **	M	Issue No.	1124
LM End	11.79	Issue Type +	Ma	Location *	
Category	Supplemental			GPS Latitude/Longitude	
				Start	End
Item	DRAFT DWR UCIP LMA Responsibility			38.092076 °	38.092076 °
				-121.183118 °	-121.183118 °
DWR ID	23593				
Comment Code					
Inspector Comment					
DS_ID:23593 FS_ID:37753 EP_NO: N/A Repair Type: Non-Urgent Crossing Status: Found UCIP Comments: Some rocky debris buildup inside pipe on LS toe. FIELD_STRUCT_DESC: 24-inch corrugated metal drainage pipe through the levee, 8.5 feet below the crown. Flap gate on the waterside (WS) end. Concrete U-shaped headwalls on both ends. Cobble grouted spillway across the berm. Cobble grouted apron on the landside (LS) end. [Additional Reference(s): DWR Levee Log, 1987. USACE San Joaquin O&M Manual 612.2, 1967, (HLM 12.30)]. FS Date: 5/14/2014

Pipe and headwall on LS toe.

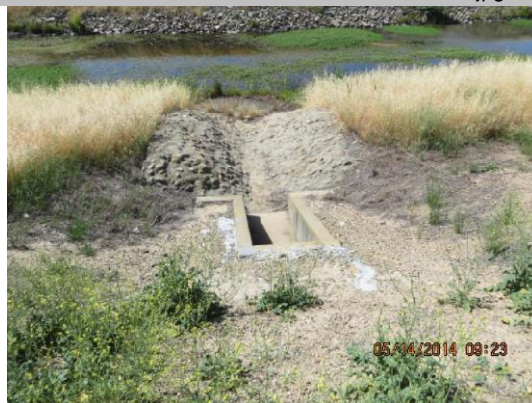
Photo 2 of 3 : UCIP_FA_2019_37753_68593.jpg

Pipe, flapgate, headwall, and grouted spillway on WS toe.

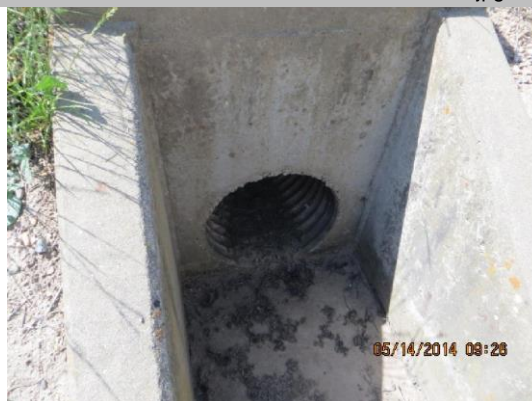
Photo 3 of 3 : UCIP_FA_2019_37753_68592.jpg

Pipe and headwall on LS toe.

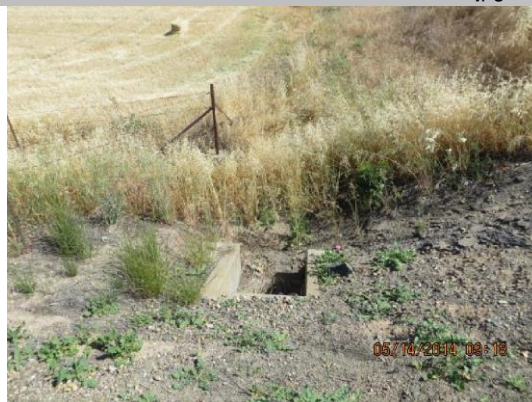
Photo 1 of 3 : UCIP_FA_2019_53044_68589.jpg

Comment Code						
Inspector Comment						
DS_ID:23594						
FS_ID:53044						
EP_NO: N/A						
Repair Type: No Action Needed						
Crossing Status: Found						
UCIP Comments: 10/10/2018 20-inch Snap-Tite lining pipes were sleeved through the damaged 24-inch CMP culvert. Annular space was pressure grouted.						
FIELD_STRUCT_DESC: 24-inch corrugated metal drainage culvert through the levee, 7.5 feet below the crown. 20-inch Snap-Tite lining pipes sleeved through the 24-inch corrugated metal drainage culvert, 10/09/2018. Annular space pressure grouted, 10/10/2018. Flap gate on the waterside (WS) end. Concrete U-shaped headwall on each end. Cobble grouted spillway across berm. Cobble grouted apron on the landside (LS) end. [Additional Reference(s): DWR Levee Log, 1987. USACE San Joaquin O&M Manual 612.2, 1967, (HLM 12.40)].						
FS Date: 10/10/2018

Pipe and headwall at the LS toe.

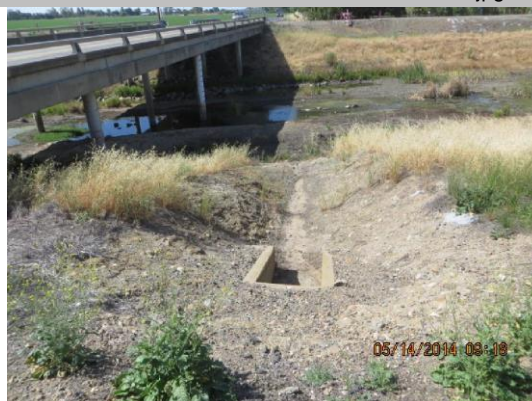
Photo 2 of 3 : UCIP_FA_2019_53044_68588.jpg

Pipe, flap gate, and headwall at the WS toe.

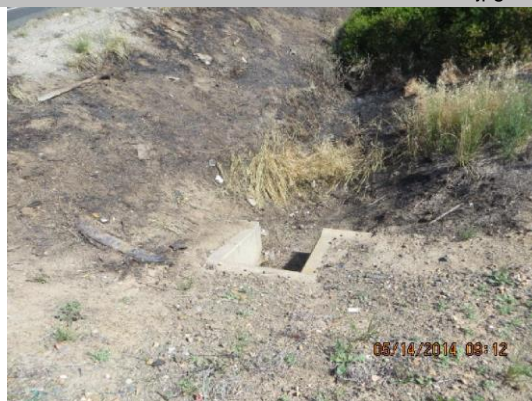
Photo 1 of 3 : UCIP_FA_2019_37751_68585.jpg

LM Start	11.90	Rating **	A/W	Issue No.	1126
LM End	11.90	Issue Type +	Ma	Location *	
Category	Supplemental			GPS Latitude/Longitude	
				Start	End
Item	DRAFT DWR UCIP LMA Responsibility			38.092293 °	38.092293 °
				-121.181078 °	-121.181078 °
DWR ID	23505				
Comment Code					
Inspector Comment					
DS_ID:23505					
FS_ID:37751					
EP_NO: N/A					
Repair Type: No Action Needed					
Crossing Status: Found					
UCIP Comments:					
FIELD_STRUCT_DESC: 24-inch corrugated metal drainage pipe through the levee, 7.5 feet below the crown. Flap gate on the waterside (WS) end. Concrete U-shaped headwalls on both ends. Cobble grouted spillway across the berm. Cobble grouted apron on the landside (LS) end. [Additional Reference(s): DWR Levee Log, 1987. USACE San Joaquin O&M Manual 612.2, 1967, (HLM 12.42)].					
FS Date: 5/14/2014

Headwall and pipe on LS toe.

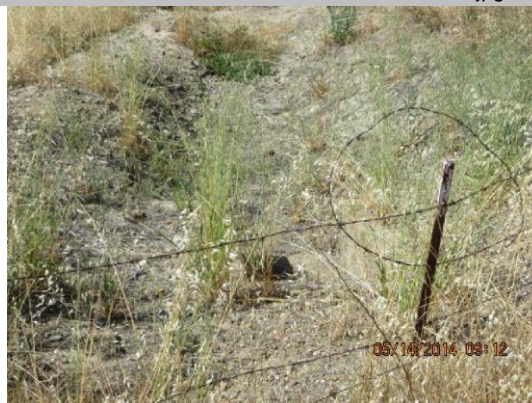
Photo 2 of 3 : UCIP_FA_2019_37751_68584.jpg

Headwall, pipe, and flapgate on WS toe.

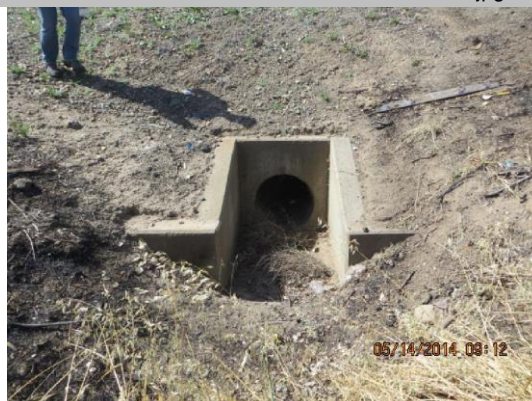
Photo 3 of 3 : UCIP_FA_2019_37751_68583.jpg

Headwall and pipe on LS toe.

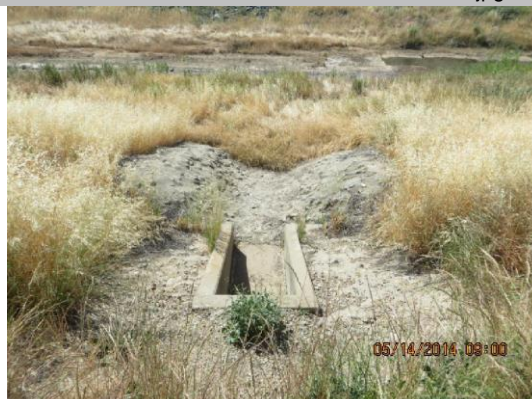
Photo 1 of 3 : UCIP_FA_2019_37745_68567.jpg

Comment Code						
Inspector Comment						
DS_ID:23507						
FS_ID:37745						
EP_NO: N/A						
Repair Type: No Action Needed						
Crossing Status: Found						
UCIP Comments:						
FIELD_STRUCT_DESC: 24-inch corrugated metal storm drainage pipe through the levee, 7.5 feet below the crown. Flap gate on the waterside (WS) end. Concrete U-shaped headwalls on both ends. Cobble grouted spillway across the berm. Cobble grouted apron on the landside (LS) end. [Additional Reference(s): DWR Levee Log, 1987. USACE San Joaquin O&M Manual 612.2, 1967, (HLM 12.64) and 612 (addendum), February 1999, (HLM 12.61) (Station 666+02)].						
FS Date: 5/14/2014

Pipe, flapgate, headwall, and grouted spillway on WS toe.

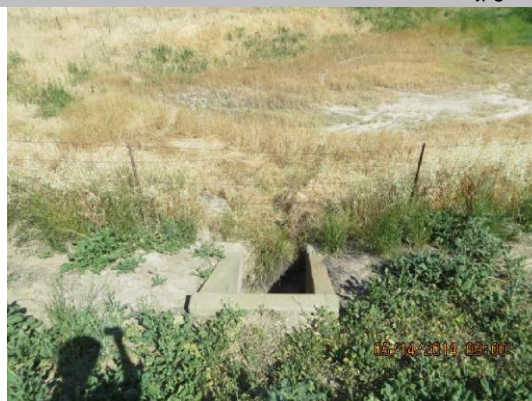
Photo 2 of 3 : UCIP_FA_2019_37745_68566.jpg

Pipe and headwall on LS toe.

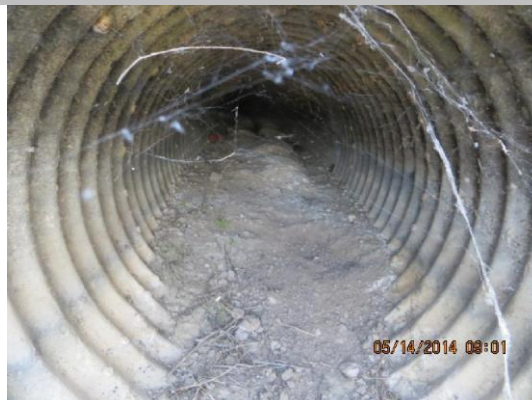
Photo 3 of 3 : UCIP_FA_2019_37745_68565.jpg

Inside of pipe on LS toe. Silt buildup.

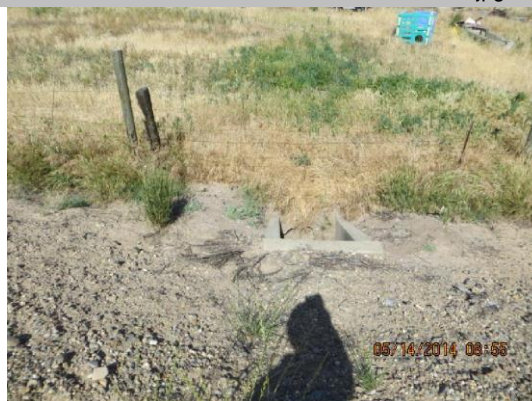
Photo 1 of 3 : UCIP_FA_2019_37732_68555.jpg

LM Start	12.19	Rating **	A/W	Issue No.	1128
LM End	12.19	Issue Type +	Ma	Location *	
Category	Supplemental			GPS Latitude/Longitude	
				Start	End
Item	DRAFT DWR UCIP LMA Responsibility			38.094163 °	38.094163 °
				-121.176824 °	-121.176824 °
DWR ID	23508				
Comment Code					
Inspector Comment					
DS_ID:23508 FS_ID:37732 EP_NO: N/A Repair Type: No Action Needed Crossing Status: Found UCIP Comments: FIELD_STRUCT_DESC: 24-inch corrugated metal storm drainage pipe through the levee, 7.5 feet below the crown. Flap gate on the waterside (WS) end. Concrete U-shaped headwalls on both ends. Cobble grouted spillway across the berm. Cobble grouted apron on the landside (LS) end. [Additional Reference(s): DWR Levee Log, 1987. USACE San Joaquin O&M Manual 612.2, 1967, (HLM 12.72) and 612 (addendum), February 1999, (HLM 12.71) (Station 671+24)]. FS Date: 5/14/2014

Pipe and headwall at LS toe.

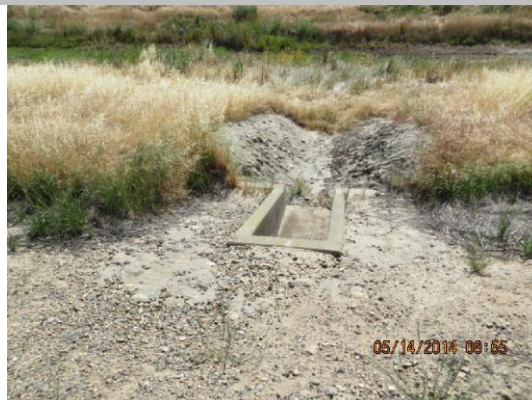
Photo 2 of 3 : UCIP_FA_2019_37732_68554.jpg

Pipe, flapgate, headwall, and grouted spillway on WS toe.

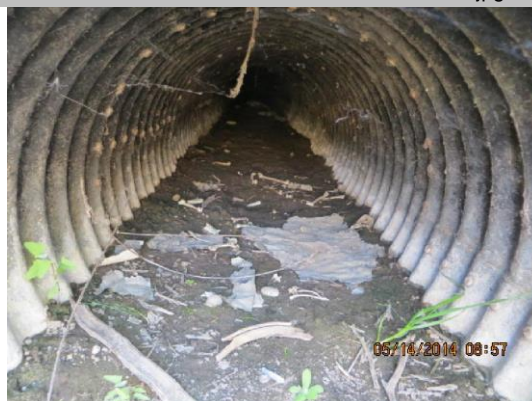
Photo 3 of 3 : UCIP_FA_2019_37732_68553.jpg

Inside pipe at LS toe.

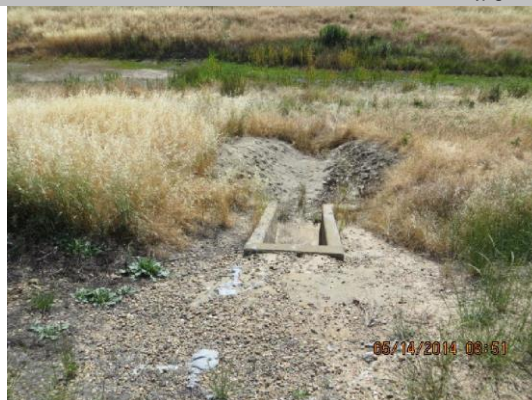
Photo 1 of 3 : UCIP_FA_2019_37731_68550.jpg

Comment Code						
Inspector Comment						
DS_ID:23509						
FS_ID:37731						
EP_NO: N/A						
Repair Type: No Action Needed						
Crossing Status: Found						
UCIP Comments:						
FIELD_STRUCT_DESC: 24-inch corrugated metal storm drainage pipe through the levee, 7.5 feet below the crown. Flap gate on the waterside (WS) end. Concrete U-shaped headwalls on both ends. Cobble grouted spillway across the berm. Cobble grouted apron on the landside (LS) end. [Additional Reference(s): DWR Levee Log, 1987. USACE San Joaquin O&M Manual 612.2, 1967, (HLM 12.74) and 612 (addendum), February 1999, (HLM 12.73) (Station 672+05)].						
FS Date: 5/14/2014

Pipe, flapgate, and headwall on WS toe.

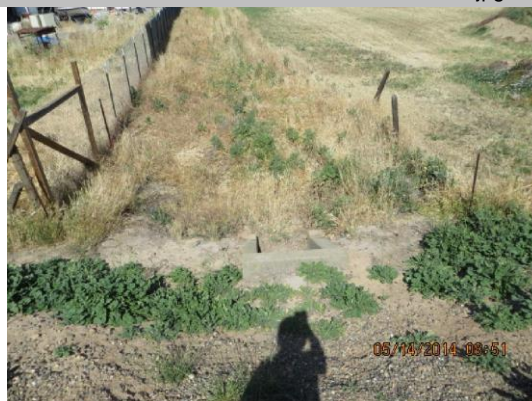
Photo 2 of 3 : UCIP_FA_2019_37731_68549.jpg

Pipe and headwall on LS toe.

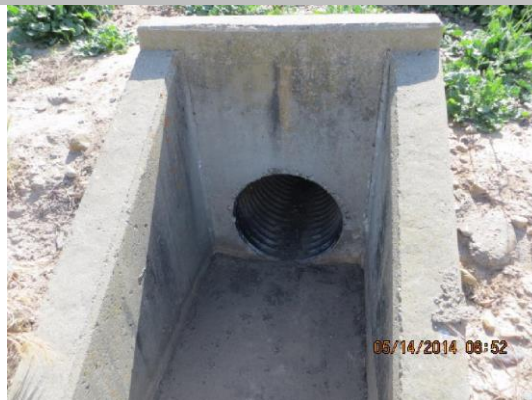
Photo 3 of 3 : UCIP_FA_2019_37731_68548.jpg

Pipe and headwall on LS toe.

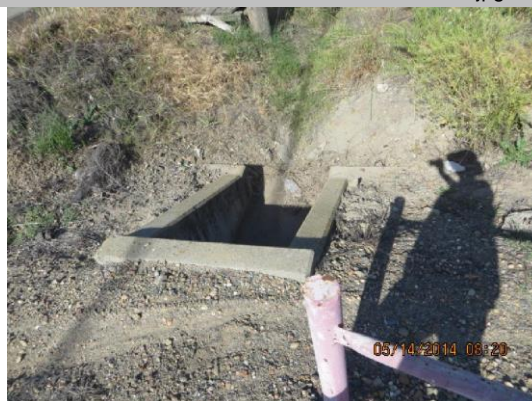
Photo 1 of 3 : UCIP_FA_2019_37719_68528.jpg

Pipe and headwall on LS toe.

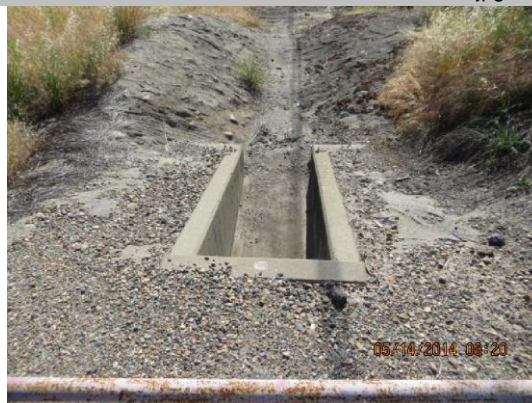
Photo 2 of 3 : UCIP_FA_2019_37719_68527.jpg

Pipe, flapgate, and headwall on WS toe.

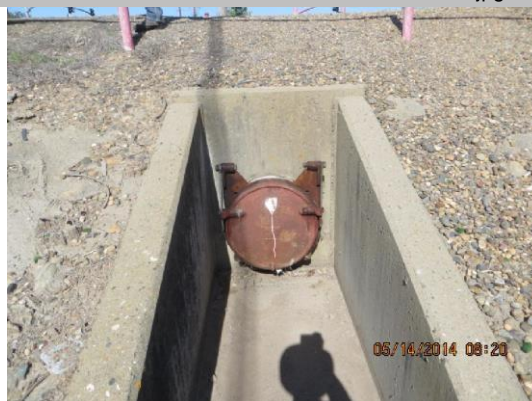
Photo 3 of 3 : UCIP_FA_2019_37719_68526.jpg

Pipe, flapgate, and headwall on WS toe.

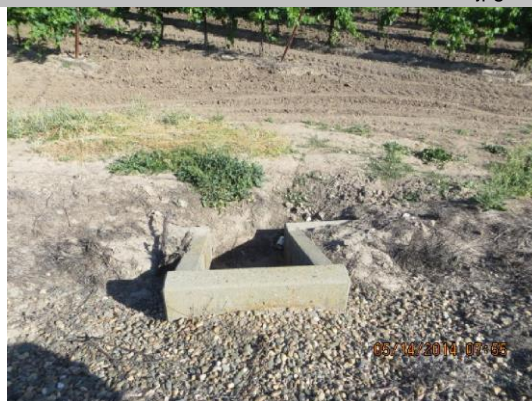
Photo 1 of 3 : UCIP_FA_2019_37690_68450.jpg

Pipe and headwall on LS toe.

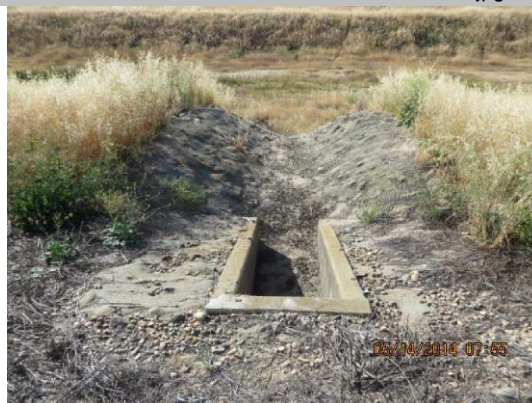
Photo 2 of 3 : UCIP_FA_2019_37690_68449.jpg

Pipe, flapgate, headwall, and grouted spillway on WS slope.

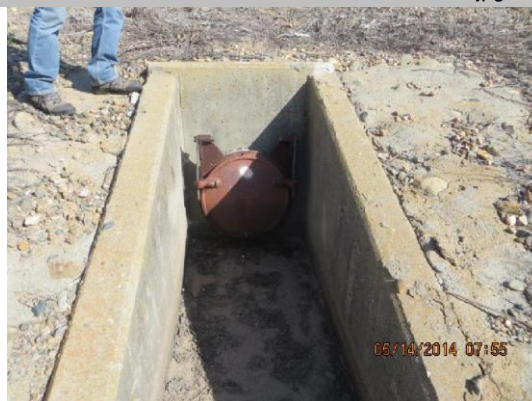
Photo 3 of 3 : UCIP_FA_2019_37690_68448.jpg

Pipe, flapgate, headwall, and grouted spillway on WS slope.

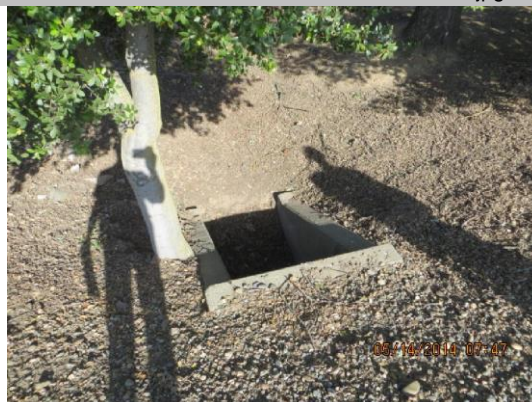
Photo 1 of 3 : UCIP_FA_2019_37689_68446.jpg

Pipe and concrete headwall on LS slope.

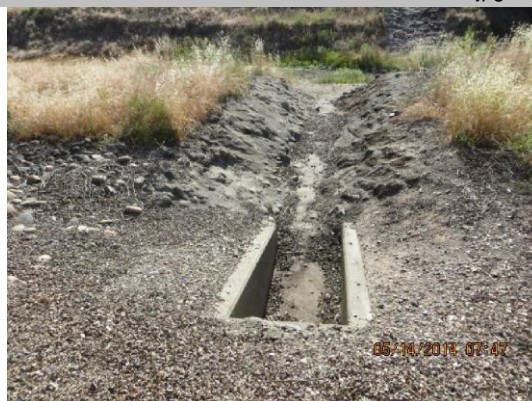
Photo 2 of 3 : UCIP_FA_2019_37689_68445.jpg

Pipe, flapgate, headwall, and grouted spillway on WS slope.

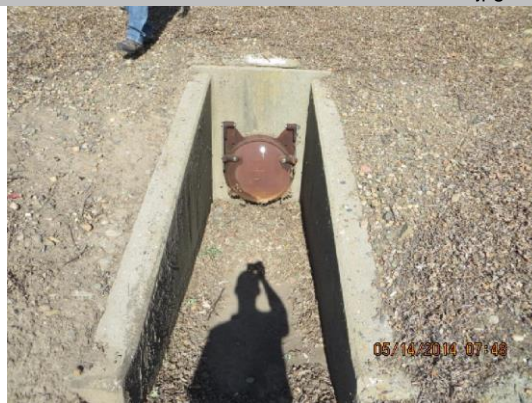
Photo 3 of 3 : UCIP_FA_2019_37689_68444.jpg

Pipe, flapgate, headwall, and grouted spillway on WS slope.

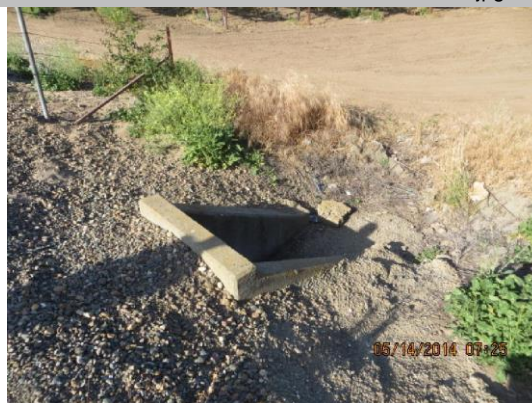
Photo 1 of 3 : UCIP_FA_2019_37675_68408.jpg

Pipe and concrete headwall on LS toe.

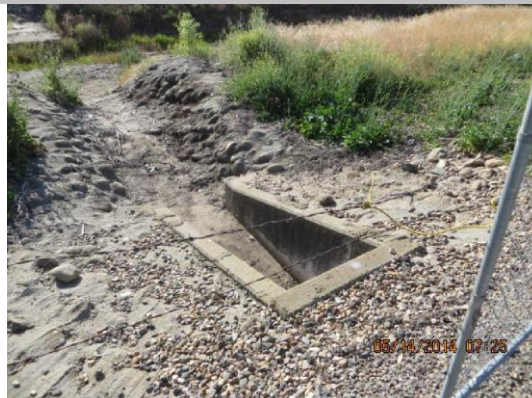
Photo 2 of 3 : UCIP_FA_2019_37675_68405.jpg

Pipe, flapgate, grouted spillway, and concrete headwall on WS toe.

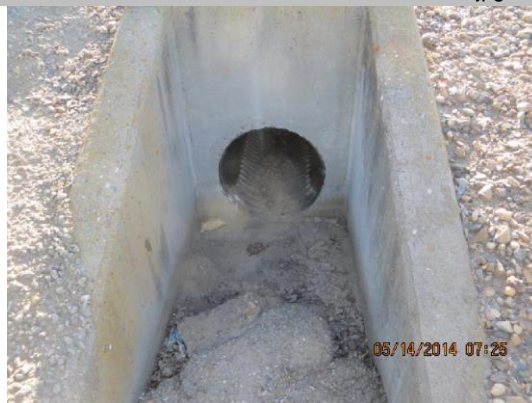
Photo 3 of 3 : UCIP_FA_2019_37675_68402.jpg

Pipe and concrete headwall on LS toe.

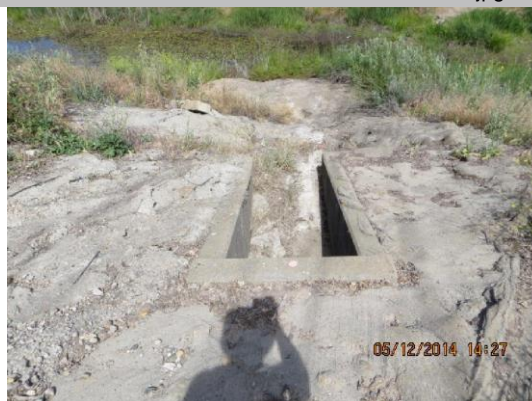
Photo 1 of 3 : UCIP_FA_2019_37666_68385.jpg

Comment Code						
Inspector Comment						
DS_ID:23601						
FS_ID:37666						
EP_NO: N/A						
Repair Type: No Action Needed						
Crossing Status: Found						
UCIP Comments:						
FIELD_STRUCT_DESC: 24-inch corrugated metal drainage pipe through the levee, 8 feet below the crown. Concrete U-shaped headwall on the waterside (WS) end. Flap gate on the WS end. Cobble grouted spillway. 24-inch corrugated metal drop inlet and cobble grouted intake on the landside (LS), no headwall. (Drainage ditch and 12-inch culverts adjacent to levee installed under Permit No. 12659, 1979 - Richard Stasand). [Additional Reference(s): DWR Levee Log, 1987. USACE San Joaquin O&M Manual 612.2, 1967, (HLM 14.39)].						
FS Date: 5/12/2014

Pipe, flapgate, and headwall on WS slope.

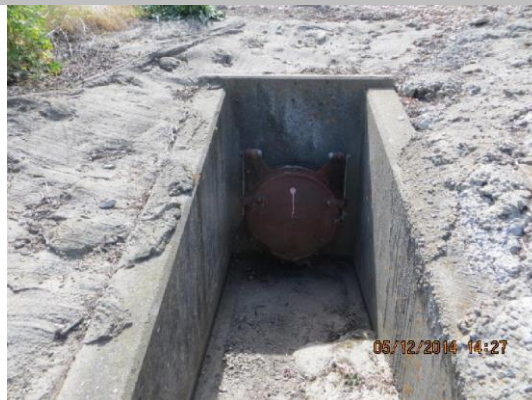
Photo 2 of 3 : UCIP_FA_2019_37666_68384.jpg

Pipe, flapgate, and headwall on WS slope.

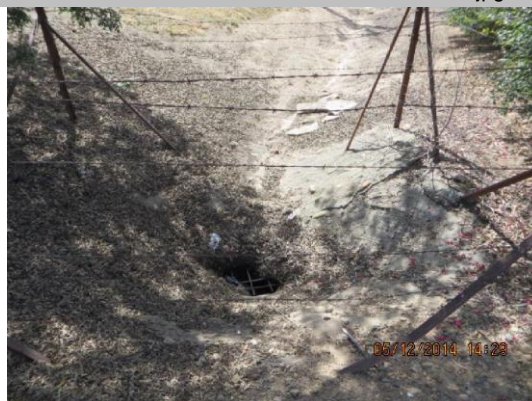
Photo 3 of 3 : UCIP_FA_2019_37666_68383.jpg

Drop-inlet on LS toe.

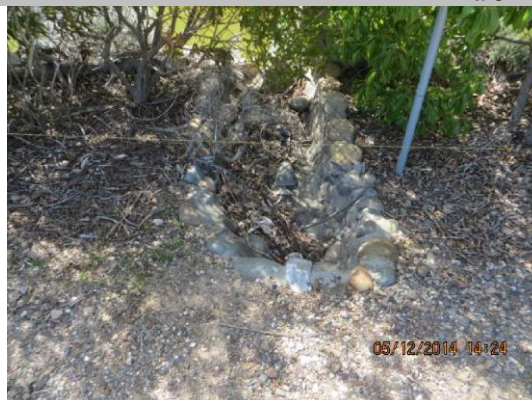
Photo 1 of 3 : UCIP_FA_2019_37663_68359.jpg

Cobble grouted inlet from fish pond on LS toe.

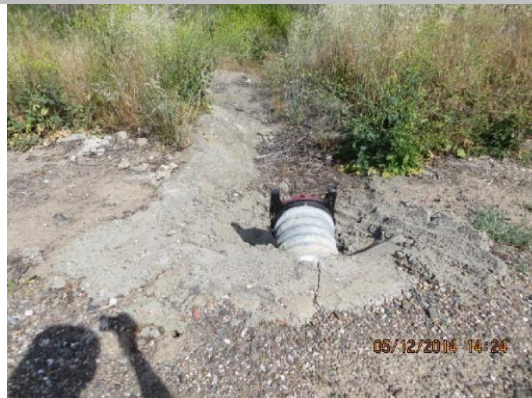
Photo 2 of 3 : UCIP_FA_2019_37663_68358.jpg

Pipe, flapgate, and grouted spillway on WS slope.

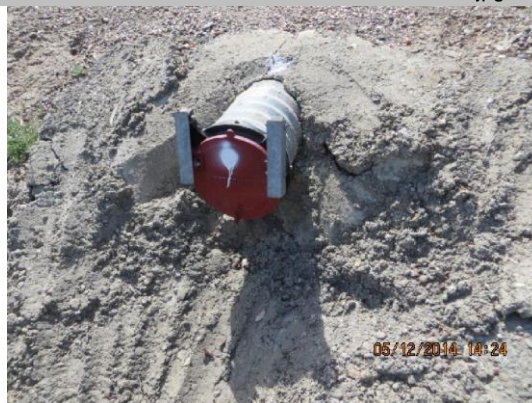
Photo 3 of 3 : UCIP_FA_2019_37663_68357.jpg

Pipe, flapgate, and grouted spillway on WS slope.

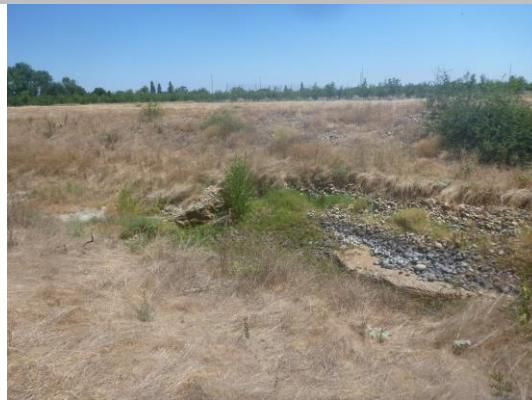
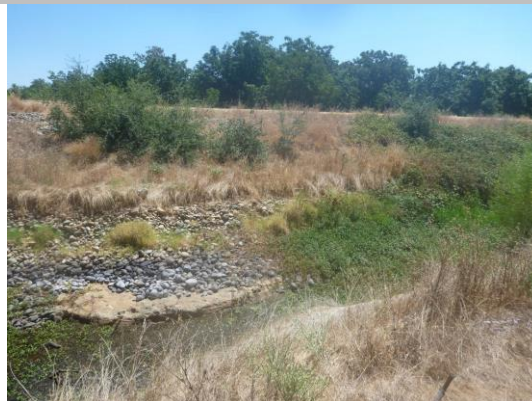
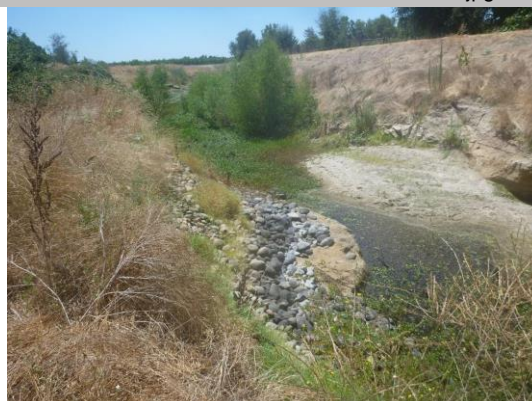
Notes: Levee is small, but there is a fairly large berm. Erosion is present on both banks with 8 ft scarp. There is a big drop in the channel bottom here that could cause eddies and faster erosion. Riprap is just cobble, not clean rock.

Item	2017 Storm Damage			38.122152 °		38.122152 °
				-121.169461 °		-121.169461 °
DWR ID	LMA-305					
Comment Code						
Inspector Comment						
Levee Evaluation Comments						
Description:Erosion on the waterside toe of the levee. The Lat, Long above is from the Spring DWR inspection report, which took the photo and GPS from the right bank. The erosion is on the left bank.						
Site ID No:478						
Site Designation:LMA-305						
Repair Type: Erosion						
Rating:Area of Concern						
Field Date:7/27/2017						
Notes: Levee is small, but there is a fairly large berm. Erosion is present on both banks with 8 ft scarp. There is a big drop in the channel bottom here that could cause eddies and faster erosion.						
Riprap is just cobble, not clean rock.

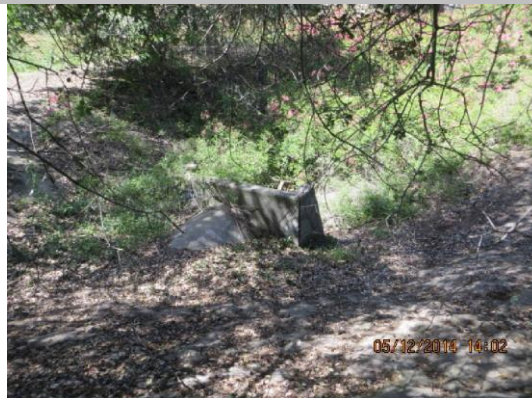
Photo 1 of 3 : UCIP_FA_2019_37660_68354.jpg

Pipe and headwall on LS toe.

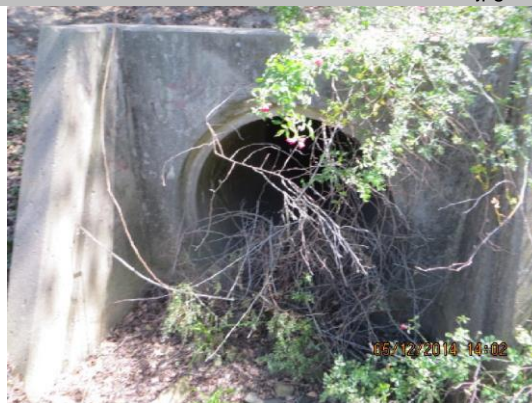
Photo 2 of 3 : UCIP_FA_2019_37660_68353.jpg

Pipe and headwall on LS toe.

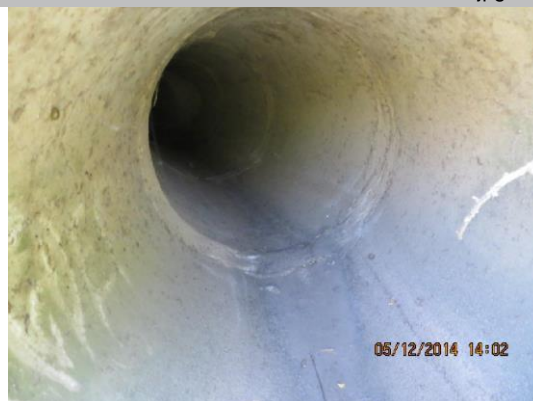
Photo 3 of 3 : UCIP_FA_2019_37660_68352.jpg

Inside concrete pipe at LS toe.

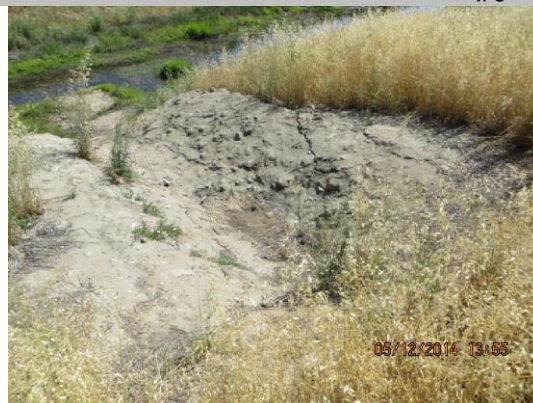
Photo 1 of 3 : UCIP_FA_2019_37658_68343.jpg

LM Start	14.54	Rating **	A/W	Issue No.	1149
LM End	14.54	Issue Type +	Ma	Location *	
Category	Supplemental			GPS Latitude/Longitude	
				Start	End
Item	DRAFT DWR UCIP LMA Responsibility			38.125671 °	38.125671 °
				-121.167975 °	-121.167975 °
DWR ID	23605				
Comment Code					
Inspector Comment					
DS_ID:23605					
FS_ID:37658					
EP_NO: N/A					
Repair Type: No Action Needed					
Crossing Status: Found					
UCIP Comments: No flapgate. Pipe not visible on LS.					
FIELD_STRUCT_DESC: 14-inch reinforced concrete drainage pipe through the levee, 4.7 feet below the crown. Cobble grouted spillway. Open on both ends. [Additional Reference(s): DWR Levee Log, 1987, 12-inch pipe listed. USACE San Joaquin O&M Manual 612.2, 1967, (HLM 15.10) 12-inch pipe listed].					
FS Date: 5/12/2014

Grouted spillway and pipe visible on WS slope.

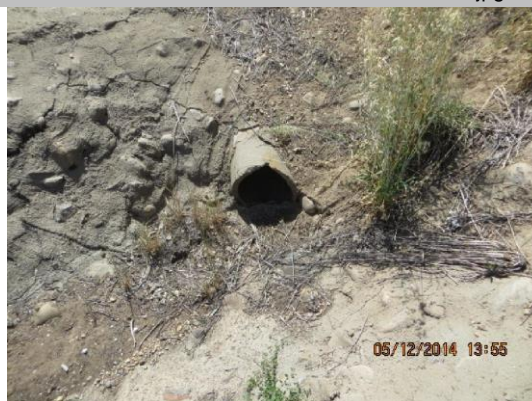
Photo 2 of 3 : UCIP_FA_2019_37658_68342.jpg

Grouted spillway and pipe visible on WS slope.

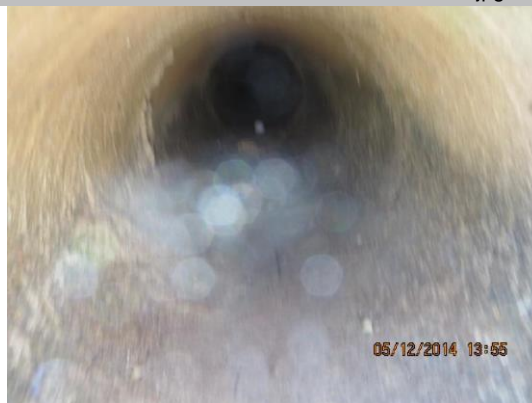
Photo 3 of 3 : UCIP_FA_2019_37658_68341.jpg

Inside pipe at WS slope.

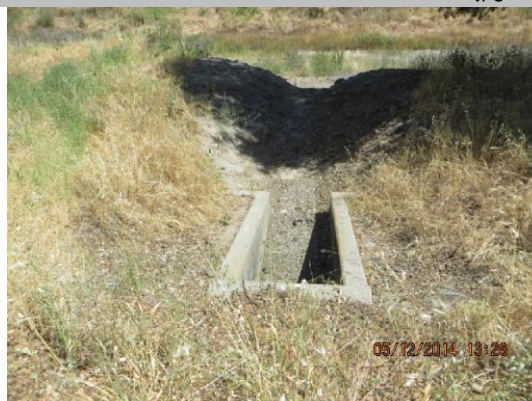
Photo 1 of 3 : UCIP_FA_2019_37655_68336.jpg

LM Start	14.93	Rating **	A/W	Issue No.	1150
LM End	14.93	Issue Type +	Ma	Location *	
Category	Supplemental			GPS Latitude/Longitude	
				Start	End
Item	DRAFT DWR UCIP LMA Responsibility			38.127941 °	38.127941 °
				-121.161531 °	-121.161531 °
DWR ID	23607				
Comment Code					
Inspector Comment					
DS_ID:23607					
FS_ID:37655					
EP_NO: N/A					
Repair Type: No Action Needed					
Crossing Status: Found					
UCIP Comments:					
FIELD_STRUCT_DESC: 24-inch corrugated metal drainage pipe through the levee, 5.5 feet below the crown. Concrete U-shaped headwalls on both ends. Flap gate on the waterside (WS) end. Cobble grouted spillway. Cobble grouted intake on the landside (LS). [Additional Reference(s): DWR Levee Log, 1987. USACE San Joaquin O&M Manual 612.2, 1967, (HLM 15.50)].					
FS Date: 5/12/2014

Pipe, flapgate, concrete headwall, and grouted spillway on WS slope.

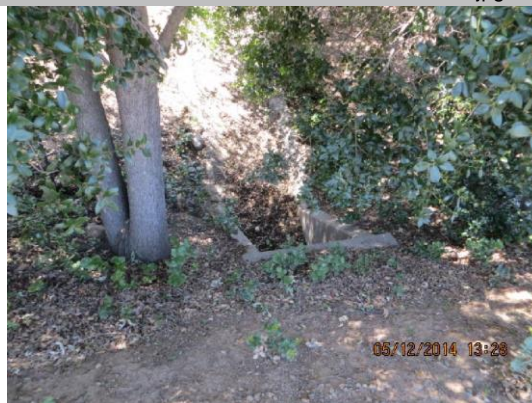
Photo 2 of 3 : UCIP_FA_2019_37655_68335.jpg

Concrete headwall and pipe at LS toe.
