**Flood Control Project Maintenance
Levee Inspections**

Maintenance Issue Types Only, Levee Inspection Report By Mile - Fall 2019

San Joaquin County Flood Control and Water Conservation District

Waterway	Bank	Unit Miles	Inspection Start/End	Inspector
Unit No. 01 Littlejohn Creek	Left	2.59	11/14/2019 11/14/2019	Alberto De Leon

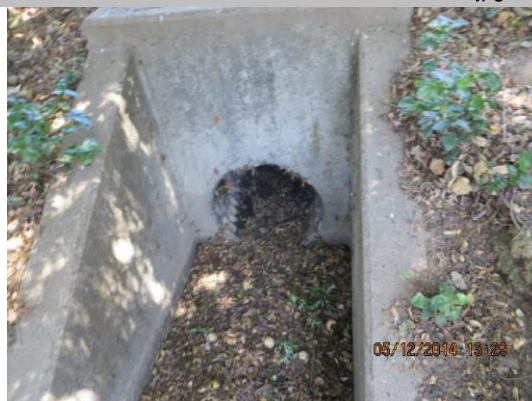
Photo 3 of 3 : UCIP_FA_2019_37655_68334.jpg

Concrete headwall and pipe at LS toe.

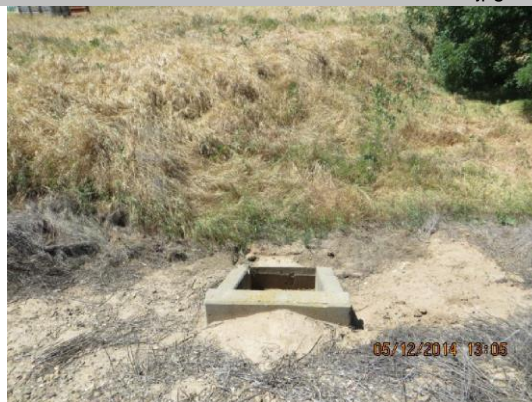
Photo 1 of 3 : UCIP_FA_2019_37653_68329.jpg

Comment Code						
Inspector Comment						
DS_ID:23609						
FS_ID:37653						
EP_NO: N/A						
Repair Type: No Action Needed						
Crossing Status: Found						
UCIP Comments: Rodent hole on crown side of headwall on WS slope.						
FIELD_STRUCT_DESC: 24-inch corrugated metal drainage pipe						
through the levee, 7.5 feet below the crown. Concrete U-shaped						
headwall on both ends. Flap gate on the waterside (WS) end. Cobble						
grouted spillway. Cobble grouted intake on the landside (LS).						
[Additional Reference(s): DWR Levee Log, 1987. USACE San Joaquin						
O&M Manual 612.2, 1967, (HLM 15.68)].						
FS Date: 5/12/2014

Concrete headwall on LS toe.

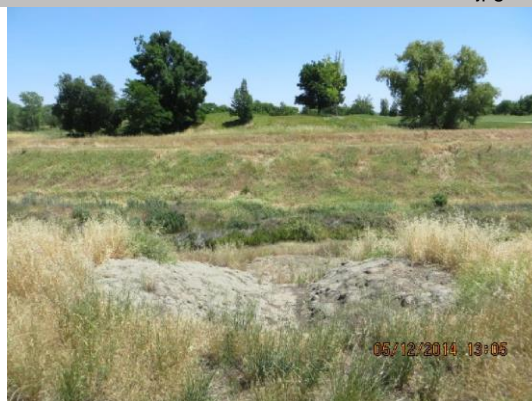
Photo 2 of 3 : UCIP_FA_2019_37653_68328.jpg

Grouted spillway on WS slope.

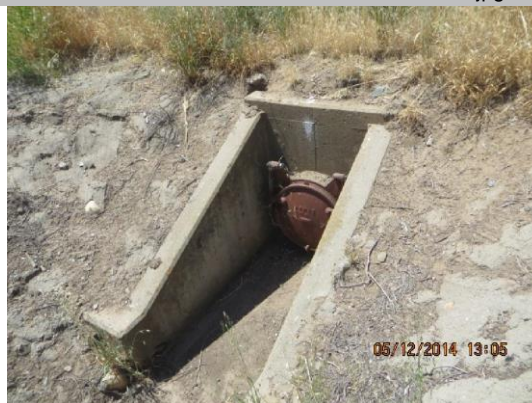
Photo 3 of 3 : UCIP_FA_2019_37653_68327.jpg

Pipe, flapgate, headwall, and grouted spillway on WS slope.

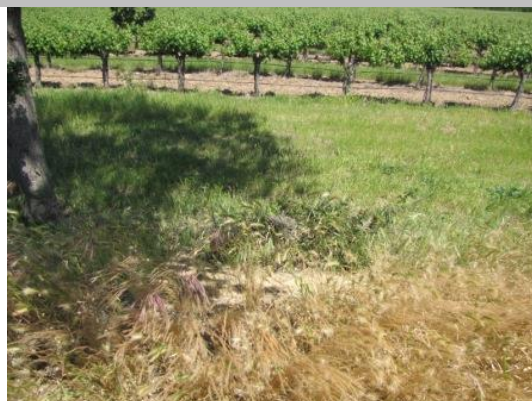
Photo 1 of 1 : FA_2019_NA0017_151_53_20190830_00017.jpg

LM Start	15.16	Rating **	N	Issue No.	53
LM End	15.16	Issue Type +	Ma	Location *	LS
Category	Earthen Levee			GPS Latitude/Longitude	
				Start	End
Item	Trim / Thin Trees			38.130231°	38.130231°
				-121.158447°	-121.158447°
DWR ID	DWR_NA0017_07_s_2012_53				
Comment Code					
T5 : Tree stumps.					
Inspector Comment

View of a stump in the landward slope.

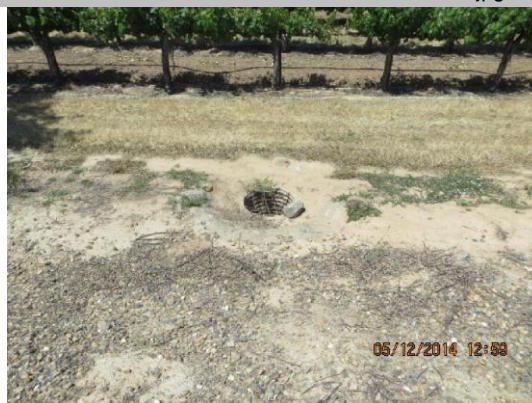
Photo 1 of 3 : UCIP_FA_2019_37652_68326.jpg

LM Start	15.22	Rating **	M	Issue No.	1154	
LM End	15.22	Issue Type +	Ma	Location *		
Category	Supplemental			GPS Latitude/Longitude		
				Start	End	
Item	DRAFT DWR UCIP LMA Responsibility			38.130318 °	38.130318 °	
				-121.157417 °	-121.157417 °	
DWR ID	23610					
Comment Code						
Inspector Comment						
DS_ID:23610						
FS_ID:37652						
EP_NO: N/A						
Repair Type: Non-Urgent						
Crossing Status: Found						
UCIP Comments: No inlet cover or grate at LS toe						
FIELD_STRUCT_DESC: 24-inch corrugated metal drainage pipe through the levee, 11 feet below the crown. Concrete U-shaped headwall on the waterside (WS) end. Flap gate on the WS end. 24-inch corrugated metal riser unit/drop inlet on the landside (LS). [Additional Reference(s): DWR Levee Log, 1987. USACE San Joaquin O&M Manual 612.2, 1967, (HLM 15.80)].						
FS Date: 5/12/2014

24-inch riser/dropinlet on LS toe.

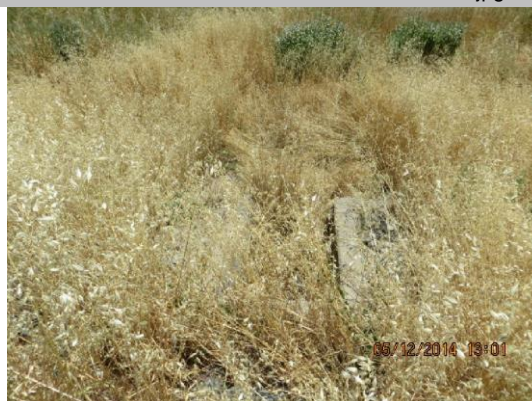
Photo 2 of 3 : UCIP_FA_2019_37652_68325.jpg

Concrete headwall on WS toe.

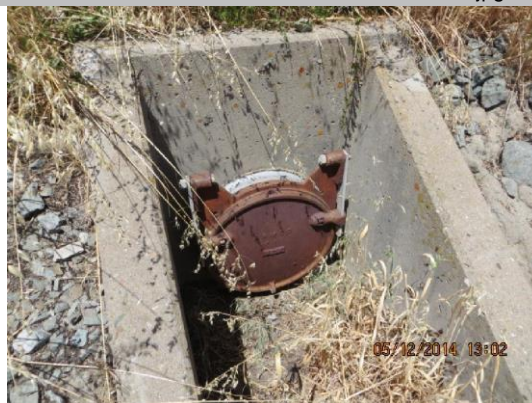
Photo 3 of 3 : UCIP_FA_2019_37652_68324.jpg

Pipe, flapgate, and Concrete headwall on WS slope.

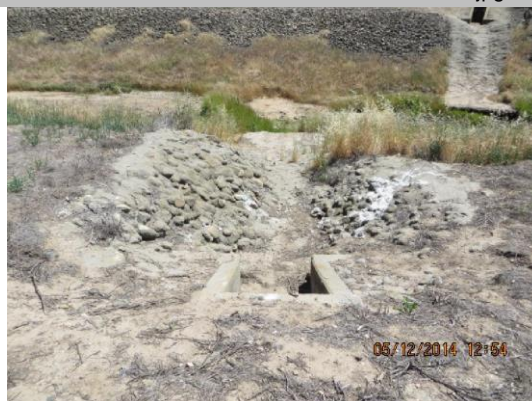
Photo 1 of 3 : UCIP_FA_2019_37651_68322.jpg

LM Start	15.31	Rating **	A/W	Issue No.	1155
LM End	15.31	Issue Type +	Ma	Location *	
Category	Supplemental			GPS Latitude/Longitude	
				Start	End
Item	DRAFT DWR UCIP LMA Responsibility			38.130361 °	38.130361 °
				-121.155686 °	-121.155686 °
DWR ID	23611				
Comment Code					
Inspector Comment					
DS_ID:23611 FS_ID:37651 EP_NO: N/A Repair Type: No Action Needed Crossing Status: Found UCIP Comments: FIELD_STRUCT_DESC: 24-inch corrugated metal drainage pipe through the levee, 4 feet below the crown. Concrete U-shaped headwall on both ends. Flap gate on the waterside (WS) end. Cobble grouted spillway. Cobble grouted intake on the landside (LS). [Additional Reference(s): DWR Levee Log, 1987. USACE San Joaquin O&M Manual 612.2, 1967, (HLM 15.90)]. FS Date: 5/12/2014

Concrete headwall and grouted spillway on WS slope.

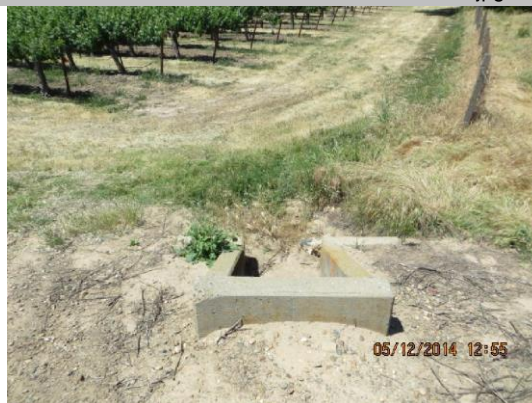
Photo 2 of 3 : UCIP_FA_2019_37651_68321.jpg

concrete headwall on LS toe.

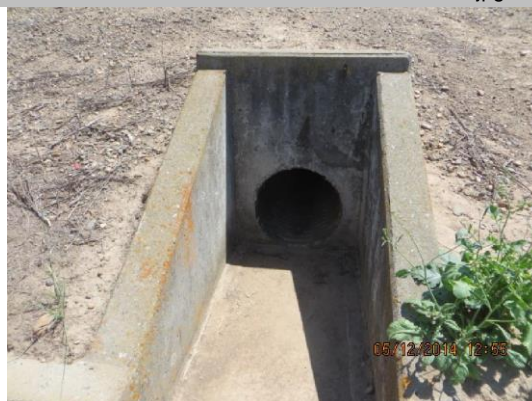
Photo 3 of 3 : UCIP_FA_2019_37651_68320.jpg

concrete headwall on LS toe.

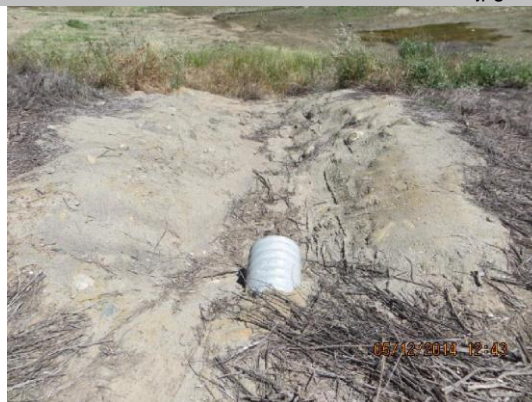
Photo 1 of 3 : UCIP_FA_2019_53498_68319.jpg

Comment Code						
Inspector Comment						
DS_ID:23612 FS_ID:53498 EP_NO: N/A Repair Type: Urgent Crossing Status: Found UCIP Comments: 09/18/2018 Levee is so short that it's almost nonexistent. Pipe goes just under levee and acts as an open storm drain. Inlet is bent down. There is a flooding potential because this pipe is open and goes straight through the levee; therefore, this crossing remains "Urgent." (A. McDonald - DWR UCIP)04/20/2017 Pipe is open on both ends. Requires a positive closure device. Crossing has been upgraded from No Action Needed to Urgent. (K. Fazel - UCIP) FIELD_STRUCT_DESC: 12-inch corrugated metal drainage culvert through the levee, 1.5 feet below the crown. Cobble grouted spillway. Open on both ends. [Additional Reference(s): DWR Levee Log, 1987. USACE San Joaquin O&M Manual 612.2, 1967, (HLM 16.10)]. FS Date: 9/18/2018

Pipe visible on WS slope with grouted spillway.

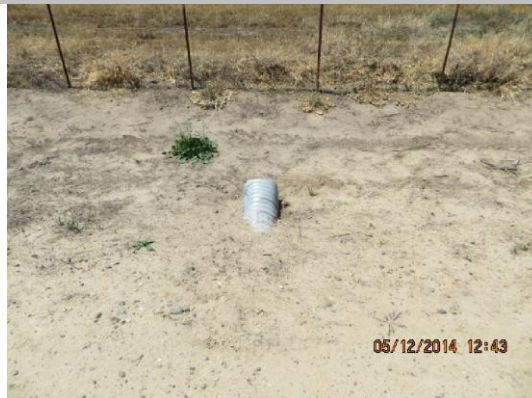
Photo 2 of 3 : UCIP_FA_2019_53498_68318.jpg

Pipe at inlet on LS toe.

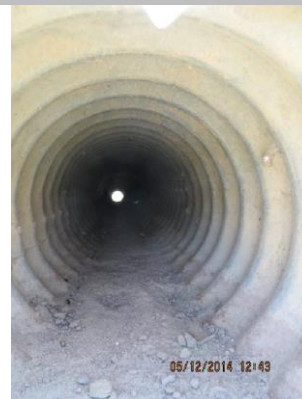
Photo 3 of 3 : UCIP_FA_2019_53498_68317.jpg

Inside pipe at LS toe.

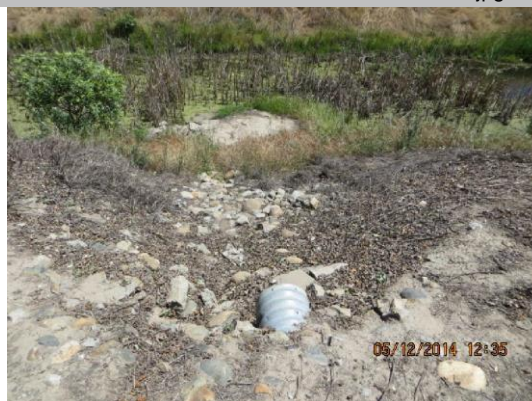
Photo 1 of 3 : UCIP_FA_2019_53499_68316.jpg

Comment Code						
Inspector Comment						
DS_ID:23614 FS_ID:53499 EP_NO: N/A Repair Type: Urgent Crossing Status: Found UCIP Comments: 09/18/2018 Levee is so short that it's almost nonexistent. Pipe goes just under levee and acts as an open storm drain. There is a flooding potential because this pipe is open and goes straight through the levee; therefore, this crossing remains "Urgent." (A. McDonald - DWR UCIP)04/20/2017 Pipe is open on both ends. Requires a positive closure device. Crossing has been upgraded from No Action Needed to Urgent. (K. Fazel - UCIP) FIELD_STRUCT_DESC: 12-inch corrugated metal drainage culvert through the levee, 2 feet below the crown. Cobble grouted spillway. Open on both ends. [Additional Reference(s): DWR Levee Log, 1987. USACE San Joaquin O&M Manual 612.2, 1967, (HLM 16.32)]. FS Date: 9/18/2018

Pipe on WS slope.

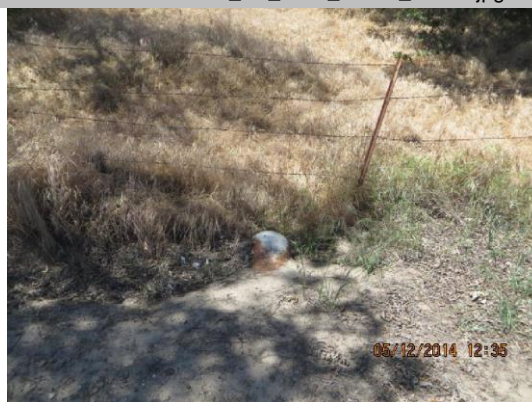
Photo 2 of 3 : UCIP_FA_2019_53499_68315.jpg

Pipe at inlet on LS shoulder.

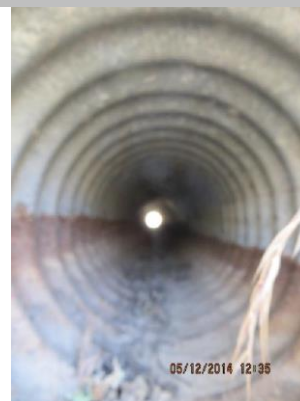
Photo 3 of 3 : UCIP_FA_2019_53499_68314.jpg

Inside pipe at LS inlet.

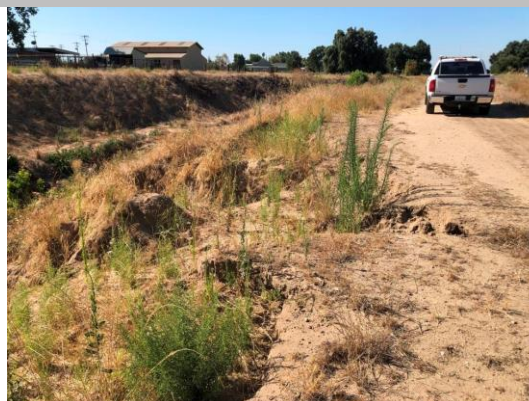
Photo 1 of 3 : SJR2019_DWR_NA0017_07_f_2018_180_4.JPG

LM Start	15.86	Rating **	A/W	Issue No.	26
LM End	15.90	Issue Type +	Ma	Location *	
Category	Supplemental			GPS Latitude/Longitude	
				Start	End
Item	DWR Erosion Survey			38.137840 °	38.137840 °
				-121.152028 °	-121.152028 °
DWR ID	NA0017U07RM23.14				
Comment Code					
Inspector Comment					
Site ID: NA0017U07RM23.14 08/01/2019: The erosion has cut into the patrol road and may impact access if not repaired. The erosion has likely been caused by surface runoff. This area is patrol road only.

Looking down at the erosion.

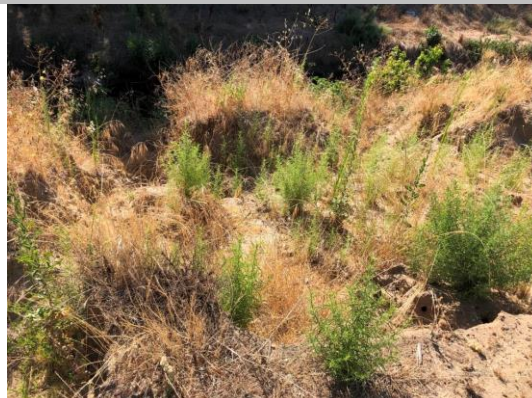
Photo 2 of 3 : SJR2019_DWR_NA0017_07_f_2018_180_3.JPG

Close view of the erosion.

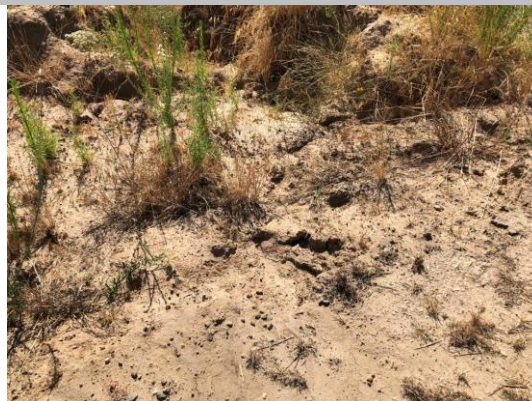
Photo 3 of 3 : SJR2019_DWR_NA0017_07_f_2018_180_5.JPG

LM Start	15.86	Rating **	A/W	Issue No.	26 (cont)	
LM End	15.90	Issue Type +	Ma	Location *		
Category	Supplemental			GPS Latitude/Longitude		
				Start		End
Item	DWR Erosion Survey			38.137840 °	38.137840 °	
				-121.152028 °	-121.152028 °	
DWR ID	NA0017U07RM23.14					
Comment Code						
Inspector Comment						
Site ID: NA0017U07RM23.14 08/01/2019: The erosion has cut into the patrol road and may impact access if not repaired. The erosion has likely been caused by surface runoff. This area is patrol road only.

Close-up view of the erosion.

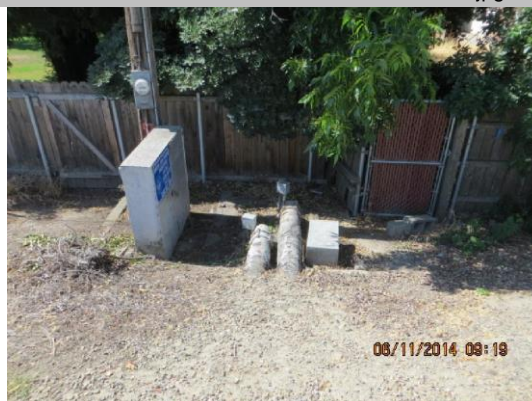
Photo 1 of 3 : UCIP_FA_2019_38523_70515.jpg

Pipe at pump and sump on LS toe next to Pole and electrical panel.

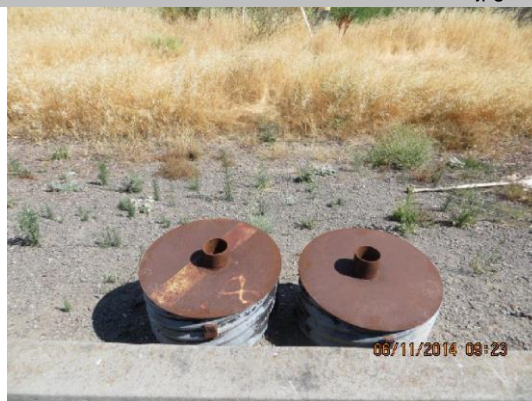
Photo 2 of 3 : UCIP_FA_2019_38523_70514.jpg

Siphon Breaker in CMP riser on WS shoulder.

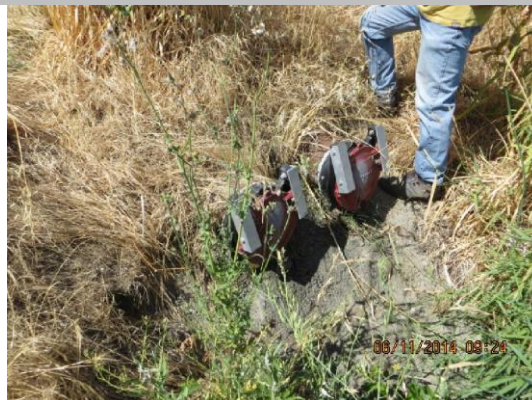
Photo 3 of 3 : UCIP_FA_2019_38523_70513.jpg

flapgate on WS slope.

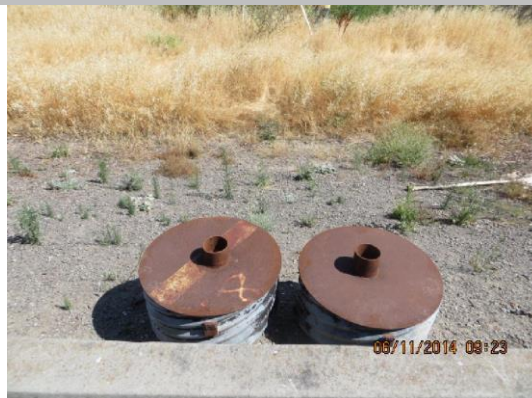
Photo 2 of 3 : UCIP_FA_2019_38524_70517.jpg

siphon breaker visible in 24-inch CMP riser on WS shoulder.

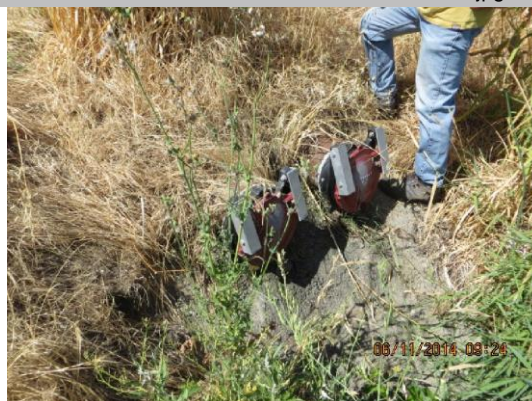
Photo 3 of 3 : UCIP_FA_2019_38524_70516.jpg

Flapgate on WS slope.

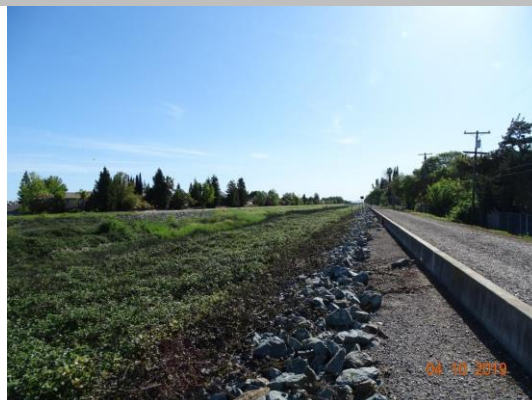
Photo 1 of 1 : FA_2019_NA0017_152_129_20190830_00021.jpg

LM Start	2.30	Rating **	U	Issue No.	129
LM End	2.38	Issue Type +	Ma	Location *	WS
Category	Earthen Levee			GPS Latitude/Longitude	
				Start	End
Item	Vegetation			38.042748 °	38.042739 °
				-121.341960 °	-121.340631 °
DWR ID	DWR_NA0017_08_s_2019_129				
Comment Code					
V2 : Remove the wild growth other than native grasses from the levee slopes.					
Inspector Comment					
Berry bushes on the waterside slope need to be removed.

View of berry bushes on waterside slope. (Spring 2019)

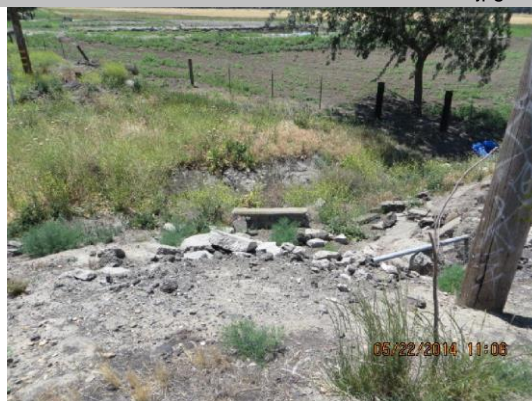
Photo 1 of 3 : UCIP_FA_2019_38510_70478.jpg

Headwall at LS toe.

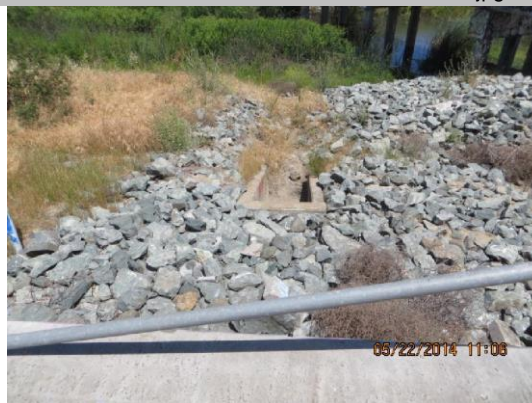
Photo 2 of 3 : UCIP_FA_2019_38510_70477.jpg

Headwall and flapgate at WS toe.

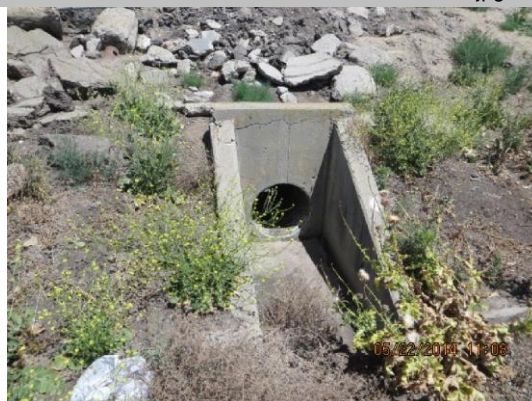
Photo 3 of 3 : UCIP_FA_2019_38510_70476.jpg

Headwall at LS toe.

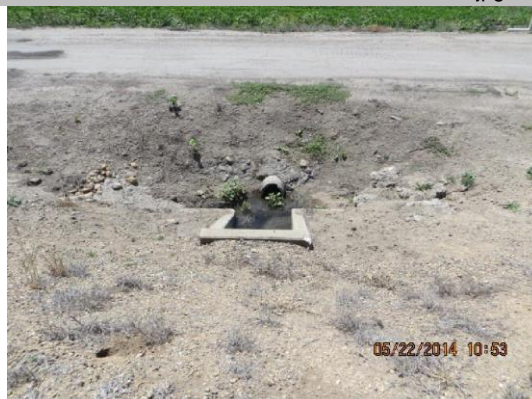
Photo 1 of 3 : UCIP_FA_2019_38507_70468.jpg

Headwall at LS toe.

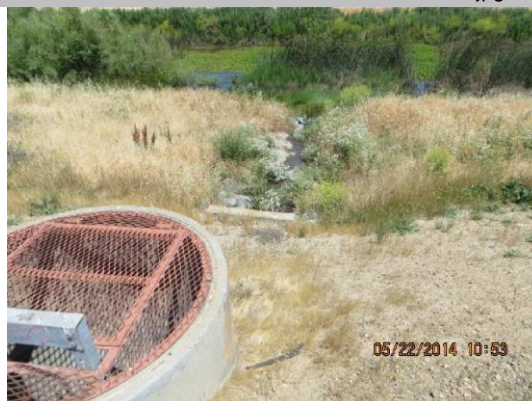
Photo 2 of 3 : UCIP_FA_2019_38507_70467.jpg

Slide gate in 72-inch concrete standpipe on WS shoulder. Headwall and flapgate visible in background on WS slope.

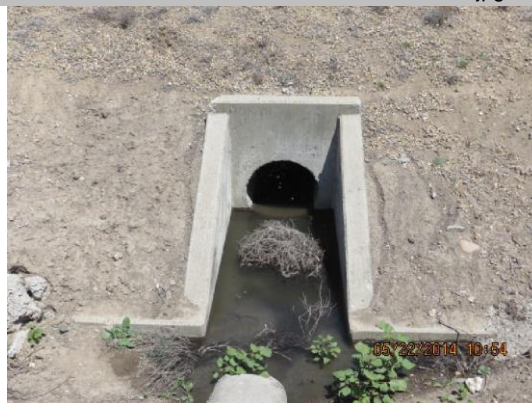
Photo 3 of 3 : UCIP_FA_2019_38507_70466.jpg

Headwall at LS toe.

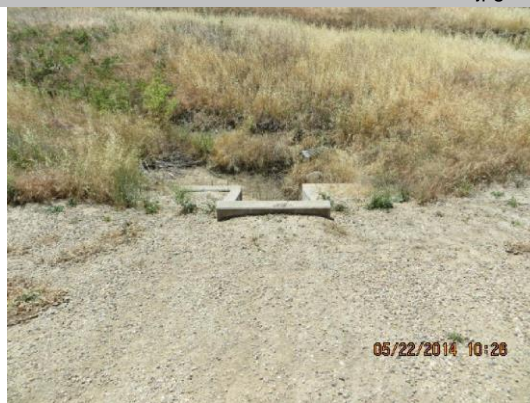
Photo 1 of 3 : UCIP_FA_2019_38477_70362.jpg

Headwall at LS toe.

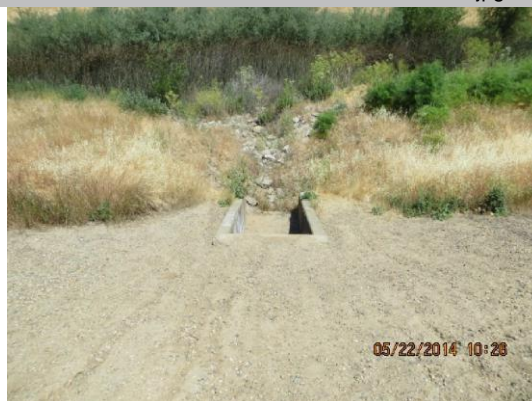
Photo 2 of 3 : UCIP_FA_2019_38477_70361.jpg

Headwall, flapgate, and grouted spillway on WS slope.

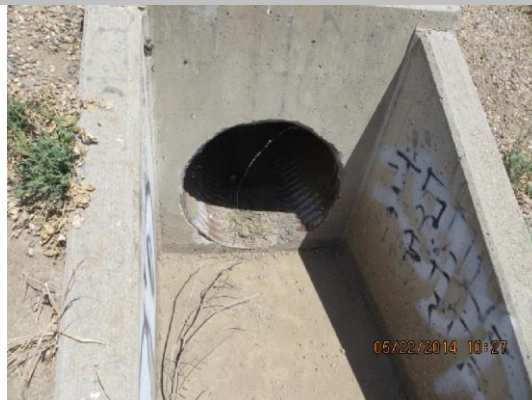
Photo 3 of 3 : UCIP_FA_2019_38477_70360.jpg

Headwall at LS toe.

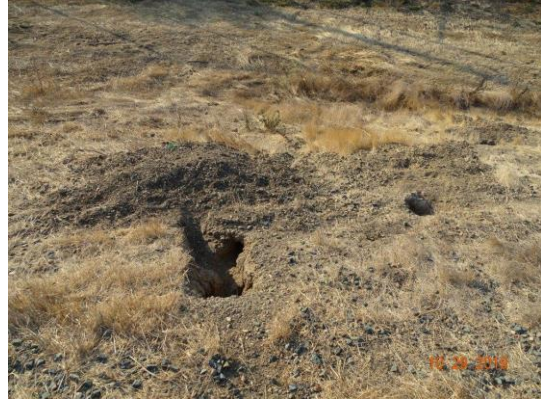
Photo 1 of 2 : FA_2019_NA0017_152_140_20191117_00316.jpg

LM Start	4.75	Rating **	U	Issue No.	140
LM End	4.75	Issue Type +	Ma	Location *	LS
Category	Earthen Levee			GPS Latitude/Longitude	
				Start	End
Item	Animal Control			38.043865 °	38.043865 °
				-121.297660 °	-121.297660 °
DWR ID	DWR_NA0017_08_s_2019_140				
Comment Code					
A3 : No rodents visible, but rodent burrows visible; need to backfill and compact or grout burrows.					
Inspector Comment

View of large rodent hole on landside slope. Fall 2019

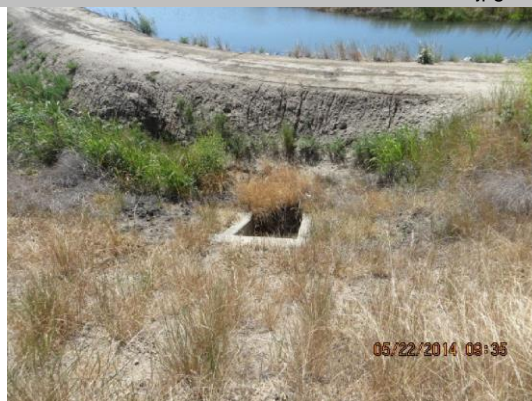
Photo 1 of 3 : UCIP_FA_2019_38444_70291.jpg

Headwall on LS toe.

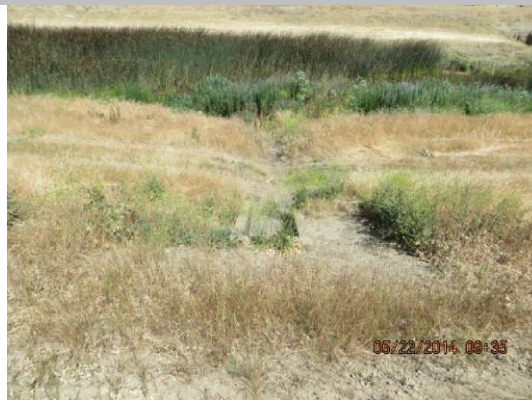
Photo 2 of 3 : UCIP_FA_2019_38444_70290.jpg

Headwall, flapgate, and grouted spillway on WS toe.

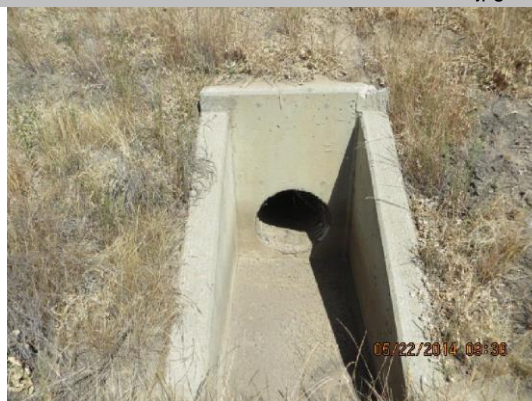
Photo 3 of 3 : UCIP_FA_2019_38444_70289.jpg

Headwall on LS toe.

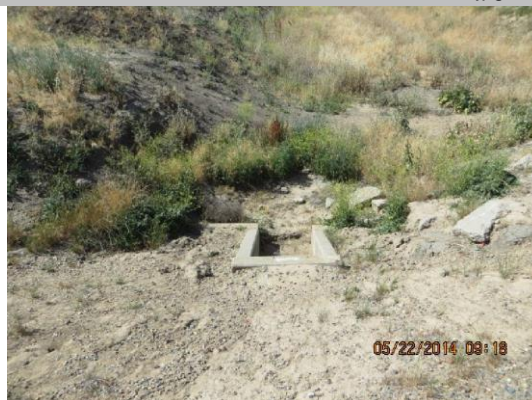
Photo 1 of 3 : UCIP_FA_2019_38427_70280.jpg

Headwall on LS toe.

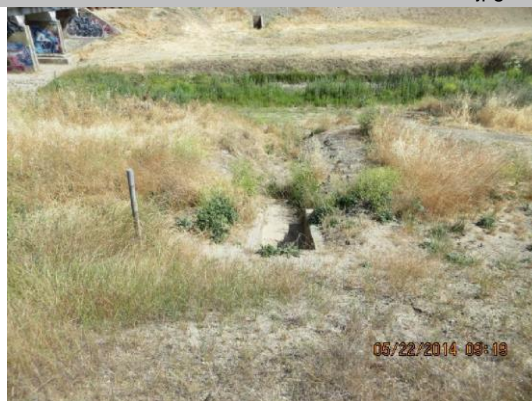
Photo 2 of 3 : UCIP_FA_2019_38427_70279.jpg

Headwall, flapgate, and grouted spillway on WS toe.

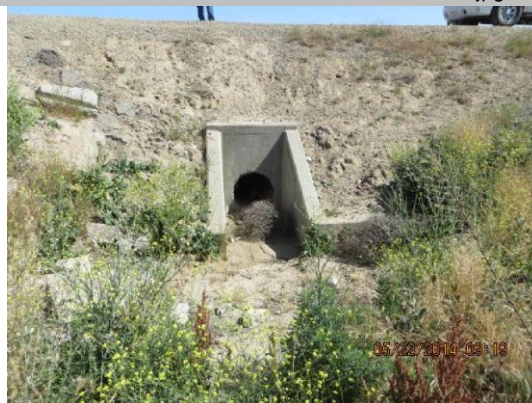
Photo 3 of 3 : UCIP_FA_2019_38427_70278.jpg

Headwall on LS toe.

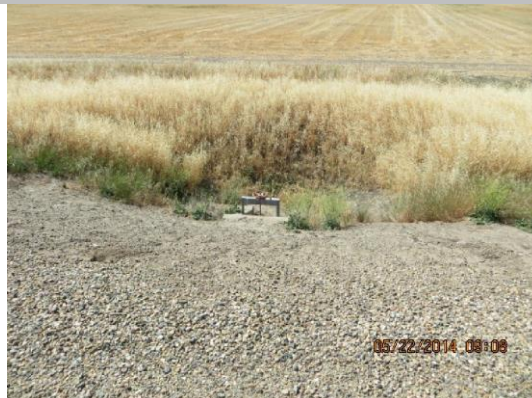
Photo 1 of 3 : UCIP_FA_2019_38373_70038.jpg

LM Start	6.20	Rating **	M	Issue No.	1138	
LM End	6.20	Issue Type +	Ma	Location *		
Category	Supplemental			GPS Latitude/Longitude		
				Start	End	
Item	DRAFT DWR UCIP LMA Responsibility			38.052247 °	38.052247 °	
				-121.275311 °	-121.275311 °	
DWR ID	23713					
Comment Code						
Inspector Comment						
DS_ID:23713 FS_ID:38373 EP_NO: N/A Repair Type: Non-Urgent Crossing Status: Found UCIP Comments: Gate rusted shut on LS toe. FIELD_STRUCT_DESC: 24-inch corrugated metal storm drainage pipe through the levee, 7.9 feet below the crown. Concrete U-shaped headwalls on both ends. Flap gate on the waterside (WS) end. Slide gate on the landside (LS) end. Cobble grouted spillway across berm. [Additional Reference(s): DWR Levee Log, 1990. USACE San Joaquin O&M Manual 612.1, June 1965, (HLM 6.35) and 612 (addendum), February 1999, (HLM 6.36) (Station 335+70)]. FS Date: 5/22/2014

Headwall and slidegate on LS toe.

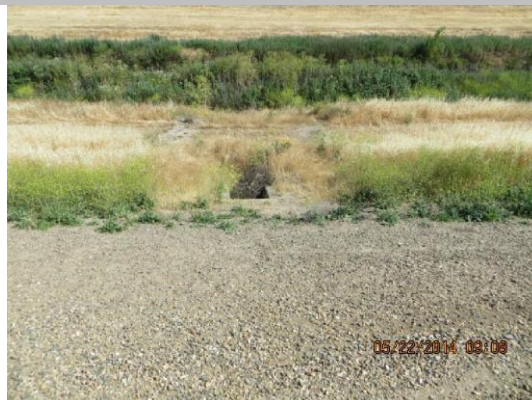
Photo 2 of 3 : UCIP_FA_2019_38373_70037.jpg

Headwall, flapgate, and grouted spillway on WS toe.

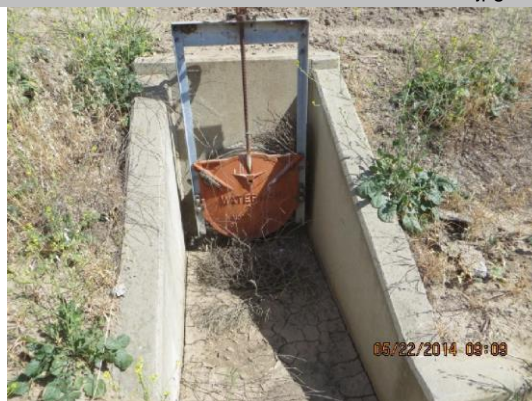
Photo 3 of 3 : UCIP_FA_2019_38373_70036.jpg

Comment Code						
Inspector Comment						
DS_ID:23713						
FS_ID:38373						
EP_NO: N/A						
Repair Type: Non-Urgent						
Crossing Status: Found						
UCIP Comments: Gate rusted shut on LS toe.						
FIELD_STRUCT_DESC: 24-inch corrugated metal storm drainage pipe through the levee, 7.9 feet below the crown. Concrete U-shaped headwalls on both ends. Flap gate on the waterside (WS) end. Slide gate on the landside (LS) end. Cobble grouted spillway across berm. [Additional Reference(s): DWR Levee Log, 1990. USACE San Joaquin O&M Manual 612.1, June 1965, (HLM 6.35) and 612 (addendum), February 1999, (HLM 6.36) (Station 335+70)].						
FS Date: 5/22/2014

Slide gate on headwall at LS toe.

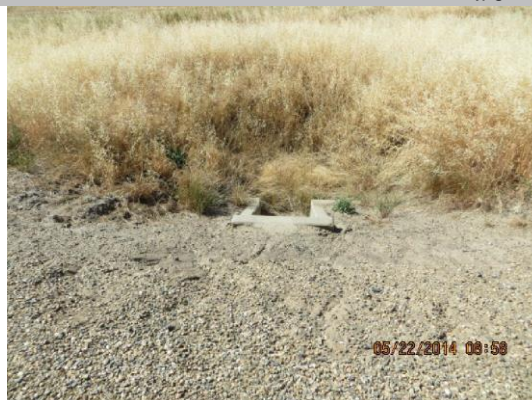
Photo 1 of 3 : UCIP_FA_2019_38368_70029.jpg

Headwall on LS toe.

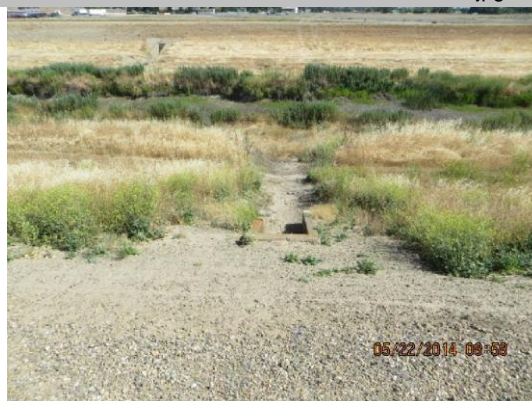
Photo 2 of 3 : UCIP_FA_2019_38368_70028.jpg

Headwall, flapgate, and grouted spillway on WS toe.

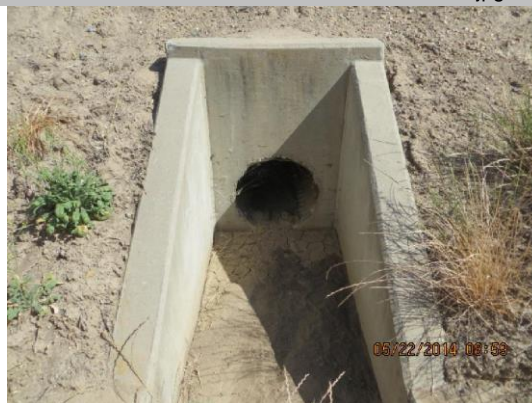
Photo 3 of 3 : UCIP_FA_2019_38368_70027.jpg

Headwall on LS toe.

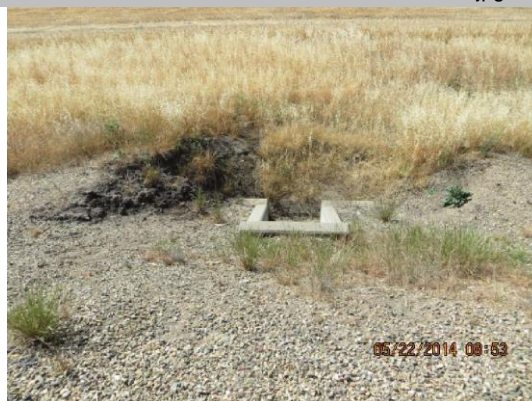
Photo 1 of 3 : UCIP_FA_2019_38367_70024.jpg

Headwall on LS toe.

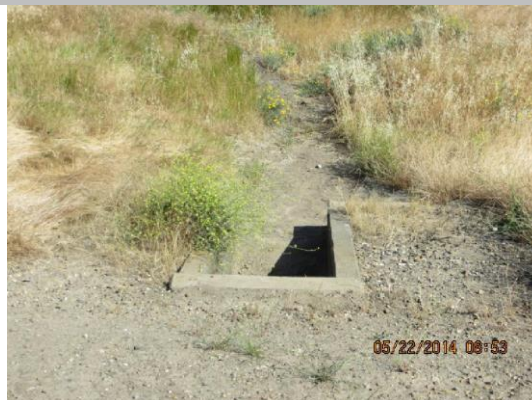
Photo 2 of 3 : UCIP_FA_2019_38367_70023.jpg

Headwall, flapgate, and grouted spillway on WS toe.

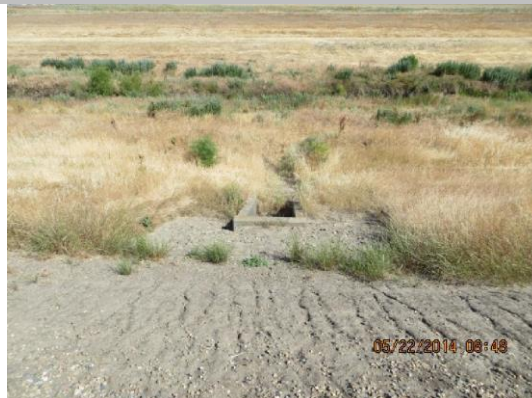
Photo 2 of 3 : UCIP_FA_2019_38365_70018.jpg

Headwall, flapgate, and grouted spillway on WS toe.

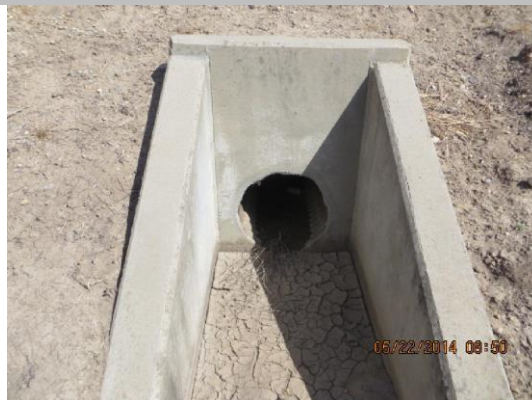
Photo 3 of 3 : UCIP_FA_2019_38365_70017.jpg

Headwall on LS toe.

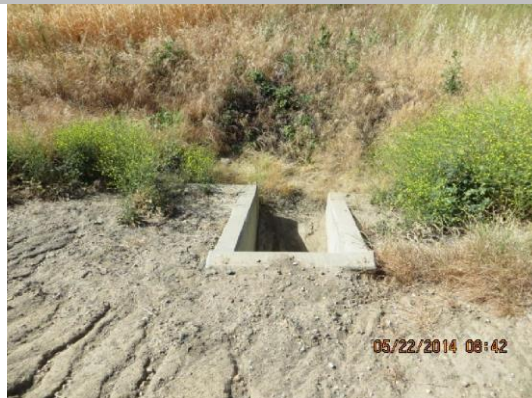
Photo 1 of 3 : UCIP_FA_2019_38363_70010.jpg

Headwall on LS toe.

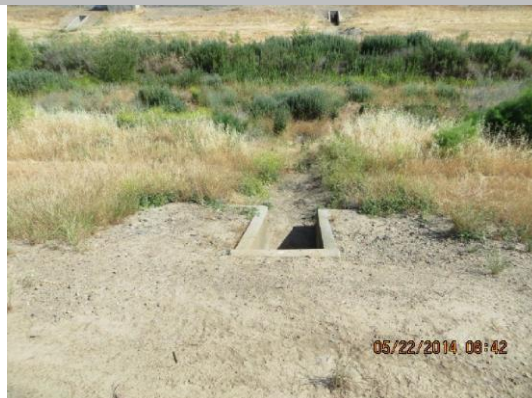
Photo 2 of 3 : UCIP_FA_2019_38363_70009.jpg

Headwall, flapgate, and grouted spillway on WS toe.

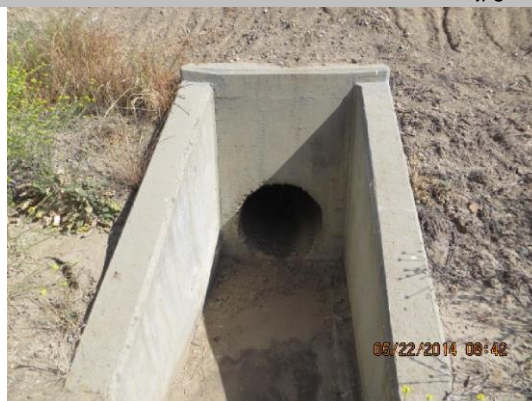
Photo 3 of 3 : UCIP_FA_2019_38363_70008.jpg

Headwall on LS toe.

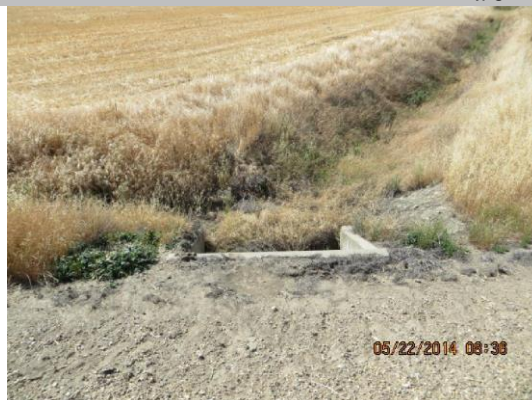
Photo 1 of 3 : UCIP_FA_2019_38361_70005.jpg

Headwall on LS toe.

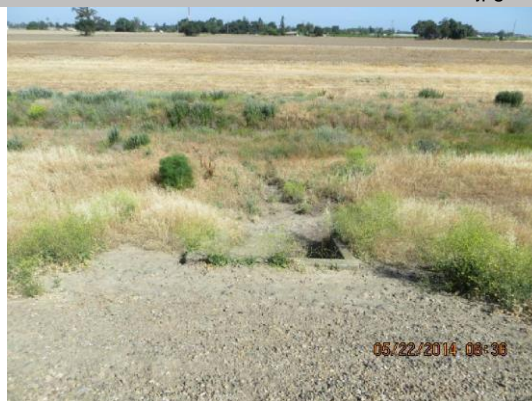
Photo 2 of 3 : UCIP_FA_2019_38361_70004.jpg

Headwall, flapgate, and grouted spillway on WS toe.

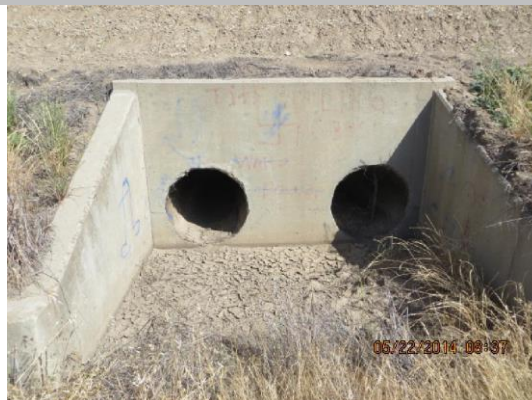
Photo 3 of 3 : UCIP_FA_2019_38361_70003.jpg

Headwall on LS toe.

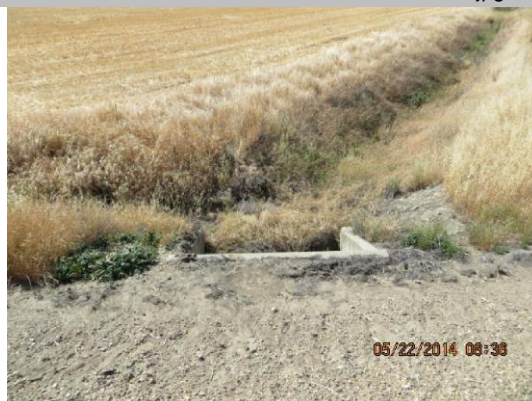
Photo 1 of 3 : UCIP_FA_2019_38360_70000.jpg

Headwall at LS toe.

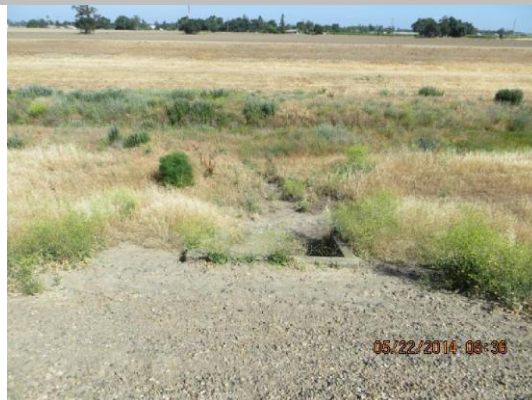
Photo 2 of 3 : UCIP_FA_2019_38360_69999.jpg

Headwall, flapgate, and grouted spillway on WS slope.

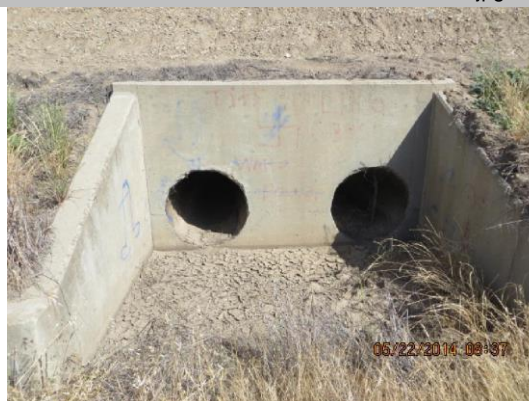
Photo 3 of 3 : UCIP_FA_2019_38360_69998.jpg

Headwall on LS toe.

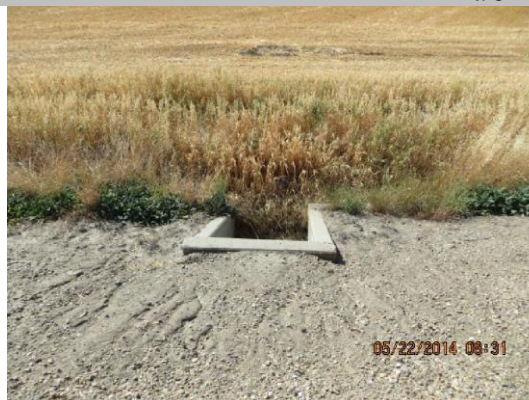
Photo 1 of 3 : UCIP_FA_2019_38359_69995.jpg

Headwall on LS toe.

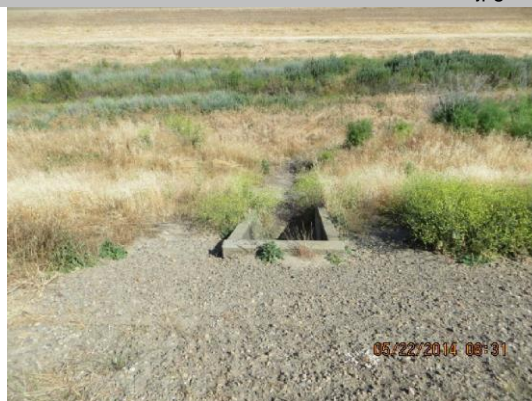
Photo 2 of 3 : UCIP_FA_2019_38359_69994.jpg

Headwall, flapgate, and grouted spillway on WS toe.

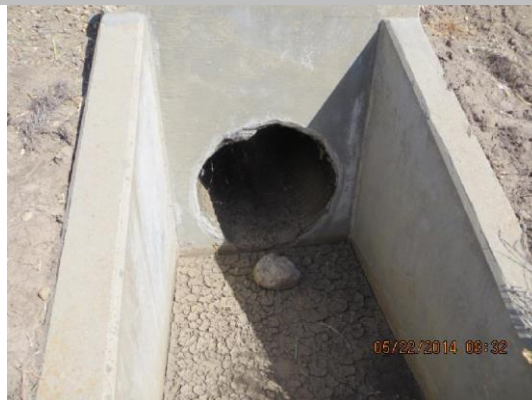
Photo 3 of 3 : UCIP_FA_2019_38359_69993.jpg

Headwall on LS toe.

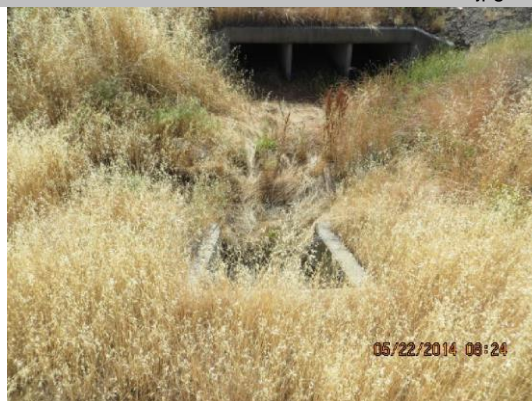
Photo 1 of 3 : UCIP_FA_2019_38358_69990.jpg

Headwall on LS toe.

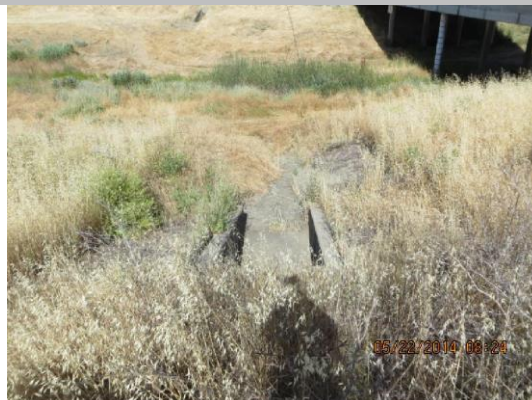
Photo 2 of 3 : UCIP_FA_2019_38358_69989.jpg

Headwall and flapgate on WS slope.

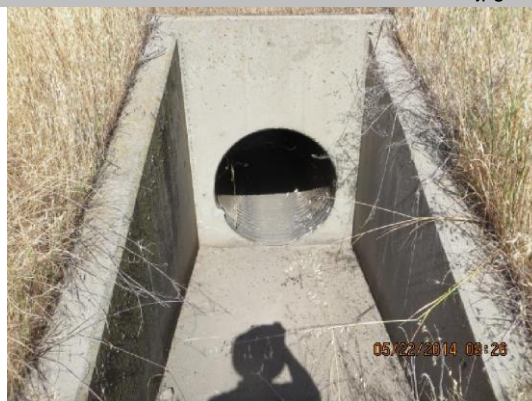
Photo 3 of 3 : UCIP_FA_2019_38358_69988.jpg

Headwall on LS toe.

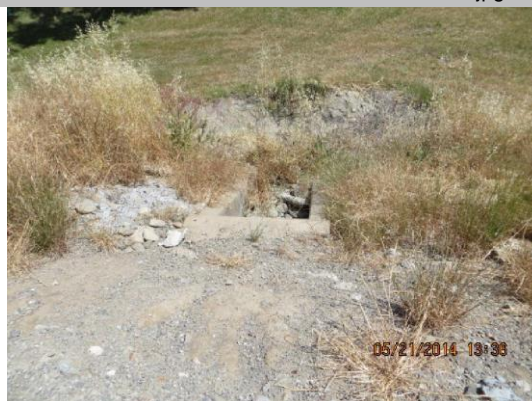
Photo 1 of 3 : UCIP_FA_2019_41809_69980.jpg

Concrete headwall on LS toe.

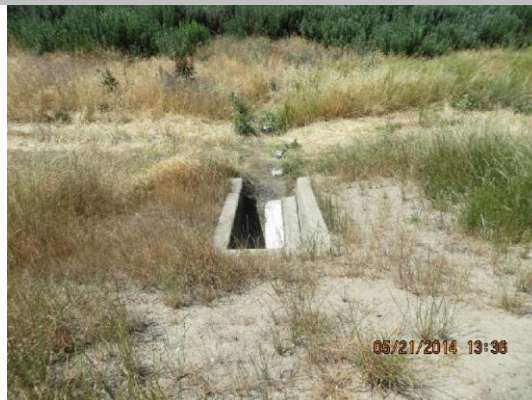
Photo 2 of 3 : UCIP_FA_2019_41809_69979.jpg

Concrete headwall and flapgate at WS toe.

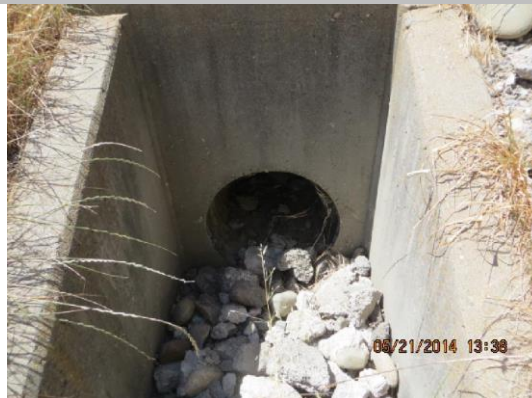
Photo 3 of 3 : UCIP_FA_2019_41809_69978.jpg

Comment Code						
Inspector Comment						
DS_ID:23743						
FS_ID:41809						
EP_NO: N/A						
Repair Type: Non-Urgent						
Crossing Status: Found						
UCIP Comments: Cobbles building up at inlet and inside pipe along with sediment.						
FIELD_STRUCT_DESC: 24-inch corrugated metal storm drainage pipe through the levee, 7 feet below the crown. Flap gate on the waterside (WS) end. Concrete U-shaped headwalls on both ends. Cobble grouted spillway across the berm. Cobble grouted apron on the landside (LS) end. [Additional Reference(s): DWR Levee Log, 1990. USACE San Joaquin O&M Manual 612.2, 1967, (HLM 7.65) and 612 (addendum), February 1999, (HLM 7.70) (Station 406+58)].						
FS Date: 5/21/2014

Concrete headwall on LS toe. Cobbles distributed at inlet.

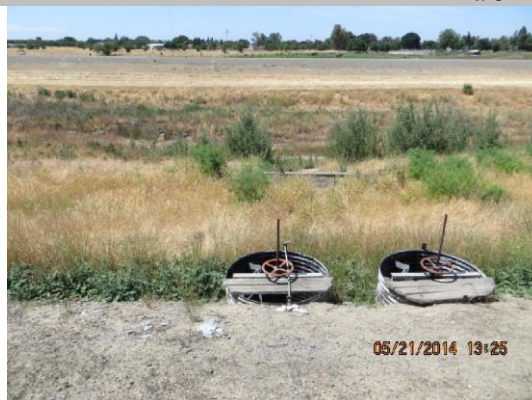
Photo 1 of 3 : UCIP_FA_2019_38352_69974.jpg

Comment Code						
Inspector Comment						
DS_ID:23744						
FS_ID:38352						
EP_NO: N/A						
Repair Type: Non-Urgent						
Crossing Status: Found						
UCIP Comments: Lid damaged/missing from CMP riser on WS slope.						
FIELD_STRUCT_DESC: 1 of 2: 36-inch corrugated metal storm drainage pipe through the levee, 9 feet below the crown. Flap gate on the waterside (WS) end. Slide gate in 48-inch corrugated metal riser unit on the WS slope. Concrete U-shaped headwalls on both ends. Cobble grouted spillway on the channel bank. Cobble grouted apron in ditch on the landside (LS). [Additional Reference(s): DWR Levee Log, 1990. USACE San Joaquin O&M Manual 612.2, 1967, (HLM 8.18) and 612 (addendum), February 1999, (HLM 8.21) (Station 433+70)].						
FS Date: 5/21/2014

Slide gate in CMP riser on WS slope. Lid missing/damaged.

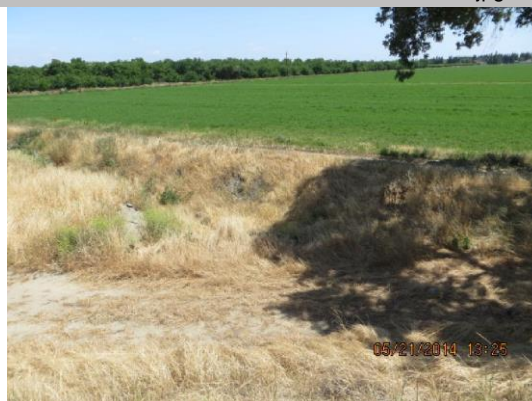
Photo 2 of 3 : UCIP_FA_2019_38352_69973.jpg

Headwall at drainage channel on LS toe.

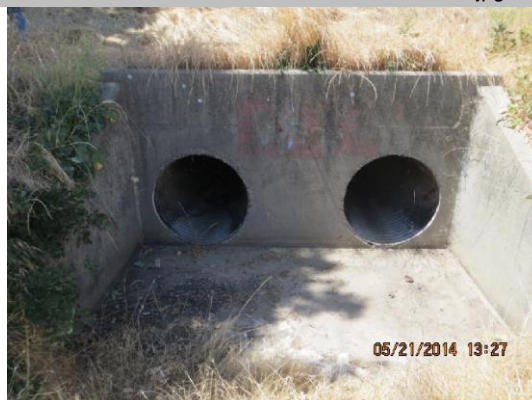
Photo 3 of 3 : UCIP_FA_2019_38352_69972.jpg

Headwall at drainage channel on LS toe.

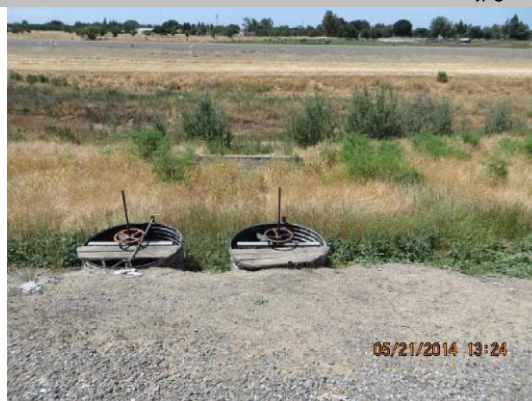
Photo 1 of 3 : UCIP_FA_2019_38351_69968.jpg

Comment Code						
Inspector Comment						
DS_ID:23820						
FS_ID:38351						
EP_NO: N/A						
Repair Type: Non-Urgent						
Crossing Status: Found						
UCIP Comments: Lid damaged/missing on 48-inch CMP riser on WS slope.						
FIELD_STRUCT_DESC: 2 of 2: 36-inch corrugated metal storm drainage pipe through the levee, 9 feet below the crown. Flap gate on the waterside (WS) end. Slide gate in corrugated metal riser units on the WS slope. Concrete U-shaped headwalls on both ends. Cobble grouted spillway on the channel bank. Cobble grouted apron in ditch on the landside (LS). [Additional Reference(s): DWR Levee Log, 1990. USACE San Joaquin O&M Manual 612.2, 1967, (HLM 8.18) and 612 (addendum), February 1999, (HLM 8.21) (Station 433+70)].						
FS Date: 5/21/2014

Slide gate in 48-inch CMP riser on WS slope. Note the missing lid material.

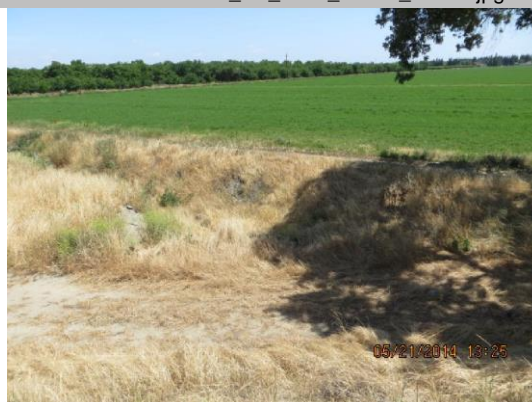
Photo 2 of 3 : UCIP_FA_2019_38351_69967.jpg

Headwall on LS toe at drainage channel.

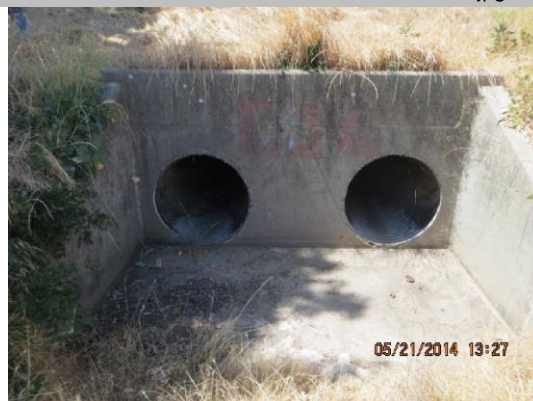
Photo 3 of 3 : UCIP_FA_2019_38351_69966.jpg

Headwall on LS toe at drainage channel.

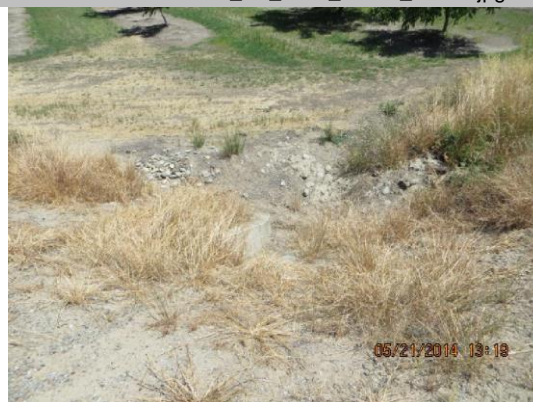
Photo 1 of 3 : UCIP_FA_2019_38350_69963.jpg

Headwall and grouted apron on LS toe.

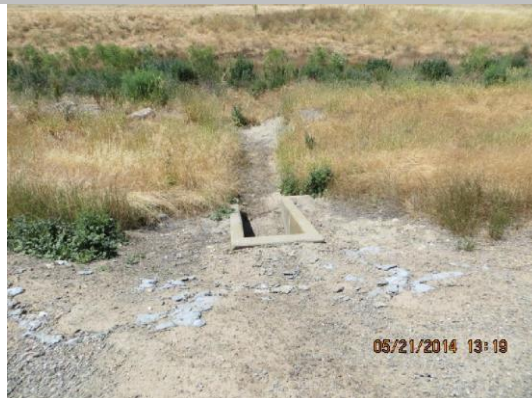
Photo 2 of 3 : UCIP_FA_2019_38350_69962.jpg

Headwall, flapgate, and grouted spillway on WS toe.

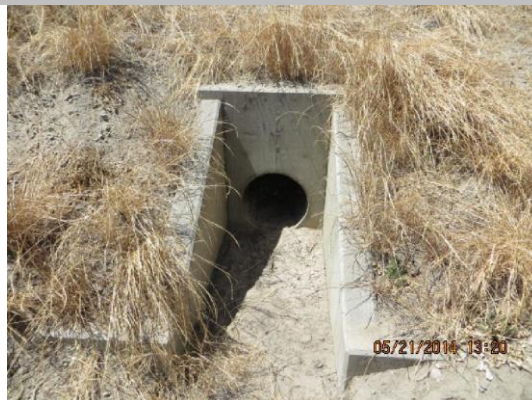
Photo 3 of 3 : UCIP_FA_2019_38350_69961.jpg

Headwall on LS toe.

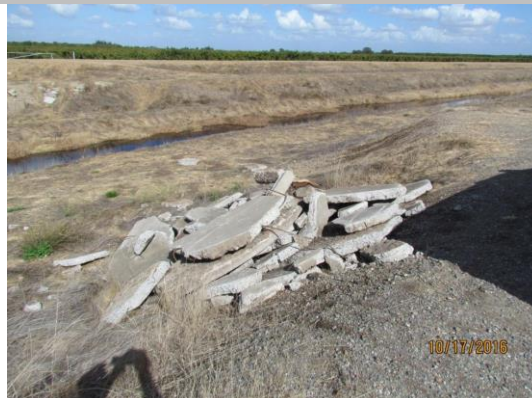
Photo 1 of 1 : FA_2019_NA0017_152_126_20190830_00019.jpg

LM Start	8.43	Rating **	M	Issue No.	126
LM End	8.43	Issue Type +	Ma	Location *	WS
Category	Earthen Levee			GPS Latitude/Longitude	
				Start	End
Item	Encroachments			38.066939 °	38.066939 °
				-121.242196 °	-121.242196 °
DWR ID	DWR_NA0017_08_f_2016_126				
Comment Code					
DE : Debris					
Inspector Comment					
There is concrete debris on the waterside slope.

View of concrete debris on the waterside of the levee. Fall 2016.

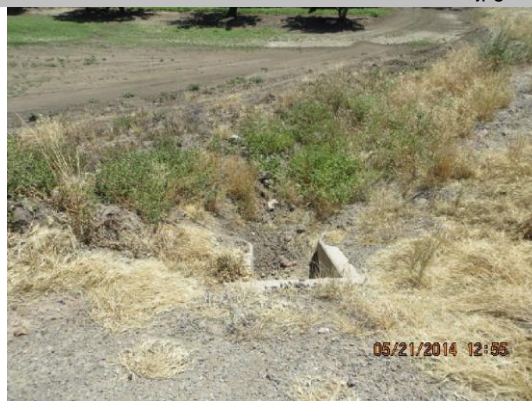
Photo 1 of 3 : UCIP_FA_2019_38346_69954.jpg

Headwall at LS toe.

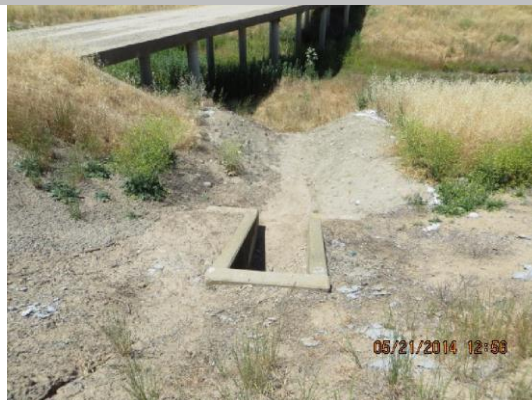
Photo 2 of 3 : UCIP_FA_2019_38346_69953.jpg

Headwall, flapgate, and grouted spillway on WS slope.

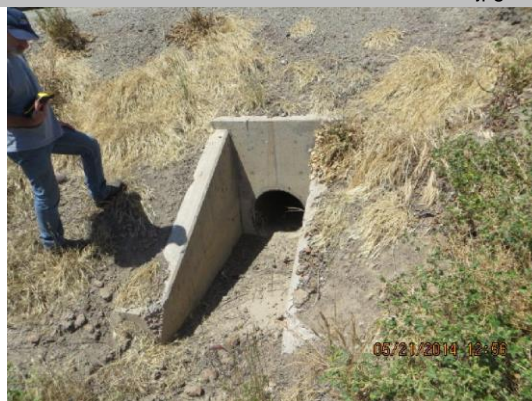
Photo 3 of 3 : UCIP_FA_2019_38346_69952.jpg

Headwall at LS toe.

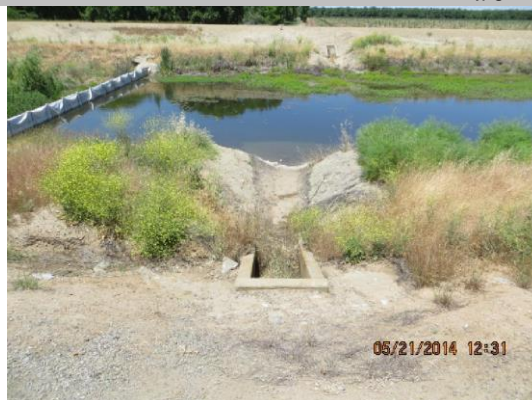
Photo 1 of 3 : UCIP_FA_2019_38241_69739.jpg

Headwall, flapgate, and grouted spillway on WS slope.

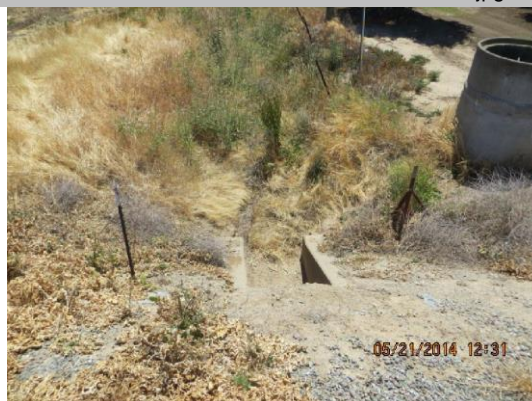
Photo 2 of 3 : UCIP_FA_2019_38241_69738.jpg

Headwall at LS toe.
