**Flood Control Project Maintenance
Levee Inspections**

Maintenance Issue Types Only, Levee Inspection Report By Mile - Fall 2019

San Joaquin County Flood Control and Water Conservation District

Waterway	Bank	Unit Miles	Inspection Start/End	Inspector
Unit No. 01 Littlejohn Creek	Left	2.59	11/14/2019 11/14/2019	Alberto De Leon

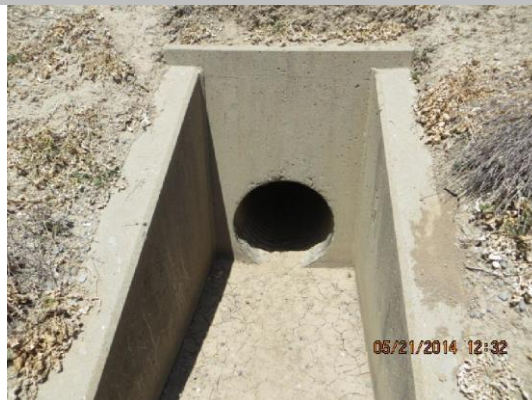
Photo 3 of 3 : UCIP_FA_2019_38241_69737.jpg

Headwall at LS toe.

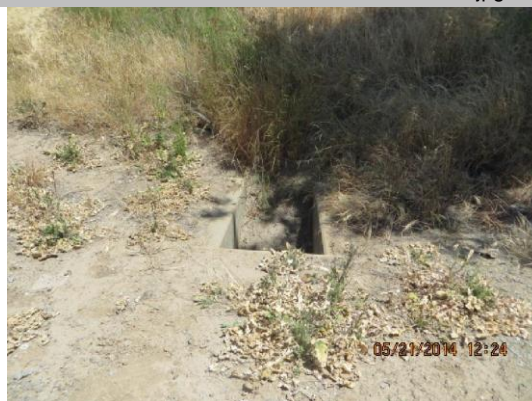
Photo 1 of 3 : UCIP_FA_2019_38239_69728.jpg

Comment Code						
Inspector Comment						
DS_ID:23727 FS_ID:38239 EP_NO: N/A Repair Type: Non-Urgent Crossing Status: Found UCIP Comments: Sediment and debris buildup inside pipe on LS toe. FIELD_STRUCT_DESC: 24-inch corrugated metal storm drainage pipe through the levee, 7 feet below the crown. Flap gate on the waterside (WS) end. Concrete U-shaped headwalls on both ends. Cobble grouted spillway across the berm. Cobble grouted apron on the landside (LS) end. [Additional Reference(s): DWR Levee Log, 1990. USACE San Joaquin O&M Manual 612.2, 1967, (HLM 10.09) and 612 (addendum), February 1999, (HLM 10.00) (Station 528+18)]. FS Date: 5/21/2014

Headwall at LS toe.

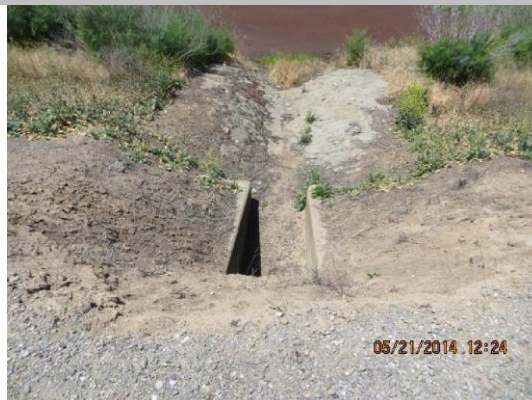
Photo 2 of 3 : UCIP_FA_2019_38239_69727.jpg

Headwall, flapgate, and grouted spillway on WS slope.

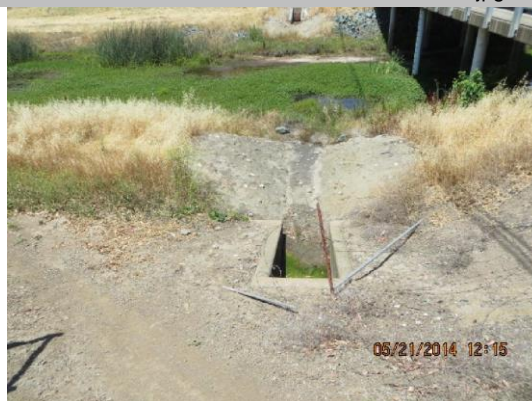
Photo 2 of 3 : UCIP_FA_2019_38232_69705.jpg

Headwall, flapgate, and grouted spillway on WS slope.

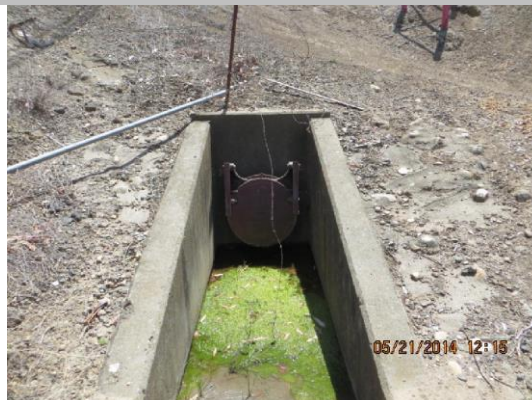
Photo 3 of 3 : UCIP_FA_2019_38232_69704.jpg

Headwall and flapgate on WS slope.

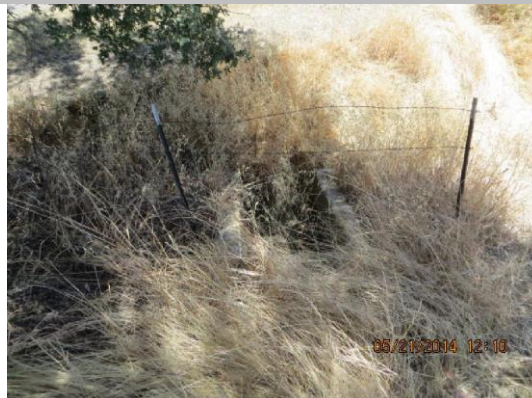
Photo 1 of 3 : UCIP_FA_2019_41808_69701.jpg

Comment Code						
Inspector Comment						
DS_ID:23729 FS_ID:41808 EP_NO: N/A Repair Type: Non-Urgent Crossing Status: Found UCIP Comments: Some sediment buildup in pipe at LS toe. FIELD_STRUCT_DESC: 24-inch corrugated metal storm drainage pipe through the levee, 7 feet below the crown. Flap gate on the waterside (WS) end. Concrete U-shaped headwalls on both ends. Cobble grouted spillway across the berm. Cobble grouted apron on the landside (LS) end. [Additional Reference(s): DWR Levee Log, 1990. USACE San Joaquin O&M Manual 612.2, 1967, (HLM 10.48) and 612 (addendum), February 1999, (HLM 10.46) (Station 552+17)]. FS Date: 5/21/2014

Headwall at LS toe.

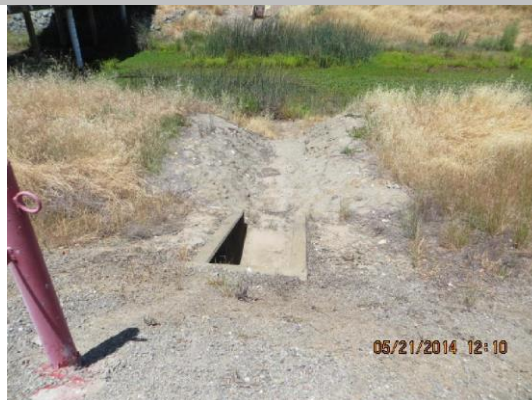
Photo 2 of 3 : UCIP_FA_2019_41808_69700.jpg

Headwall, flapgate, and grouted spillway on WS slope.

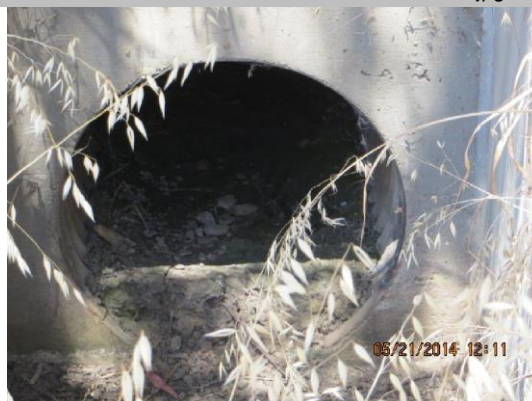
Photo 3 of 3 : UCIP_FA_2019_41808_69703.jpg

Item	DRAFT DWR UCIP LMA Responsibility			38.073725 °	38.073725 °	
				-121.211715 °	-121.211715 °	
DWR ID	23729					
Comment Code						
Inspector Comment						
DS_ID:23729 FS_ID:41808 EP_NO: N/A Repair Type: Non-Urgent Crossing Status: Found UCIP Comments: Some sediment buildup in pipe at LS toe. FIELD_STRUCT_DESC: 24-inch corrugated metal storm drainage pipe through the levee, 7 feet below the crown. Flap gate on the waterside (WS) end. Concrete U-shaped headwalls on both ends. Cobble grouted spillway across the berm. Cobble grouted apron on the landside (LS) end. [Additional Reference(s): DWR Levee Log, 1990. USACE San Joaquin O&M Manual 612.2, 1967, (HLM 10.48) and 612 (addendum), February 1999, (HLM 10.46) (Station 552+17)]. FS Date: 5/21/2014

Headwall at LS toe.

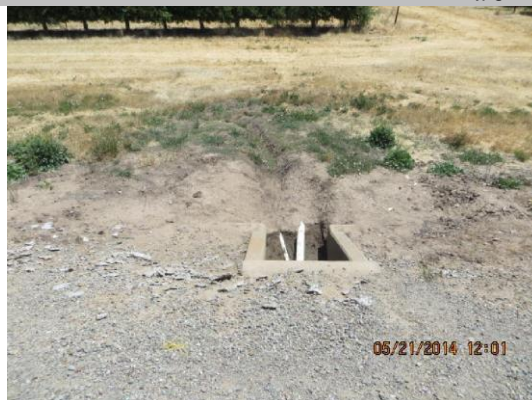
Photo 1 of 3 : UCIP_FA_2019_38229_69693.jpg

Comment Code					
Inspector Comment					
DS_ID:23748					
FS_ID:38229					
EP_NO: N/A					
Repair Type: No Action Needed					
Crossing Status: Found					
UCIP Comments: 2-small PVC pipes discharge into inlet on LS toe.					
FIELD_STRUCT_DESC: 24-inch corrugated metal storm drainage pipe through the levee, 7 feet below the crown. Flap gate on the waterside (WS) end. Concrete U-shaped headwalls on both ends. Cobble grouted spillway across the berm. Cobble grouted apron on the landside (LS) end. [Additional Reference(s): DWR Levee Log, 1990. USACE San Joaquin O&M Manual 612.2, 1967, (HLM 10.75) and 612 (addendum), February 1999, (HLM 10.72) (Station 566+09)].					
FS Date: 5/21/2014

Headwall with two PVC discharge pipes at LS toe.

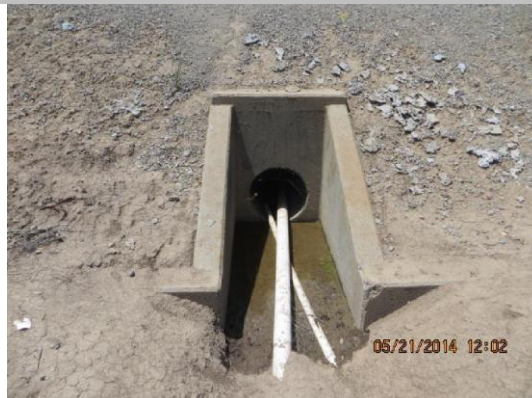
Photo 2 of 3 : UCIP_FA_2019_38229_69692.jpg

Headwall with two PVC discharge pipes at LS toe.

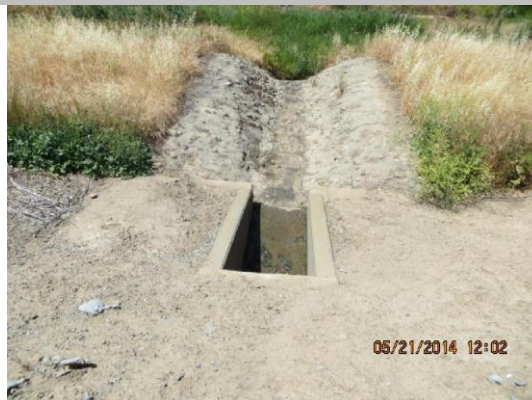
Photo 3 of 3 : UCIP_FA_2019_38229_69691.jpg

Headwall, flapgate, and grouted spillway on WS slope.

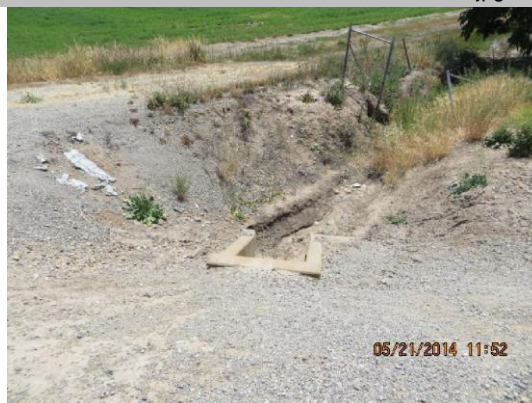
Photo 1 of 3 : UCIP_FA_2019_41810_69684.jpg

Comment Code						
Inspector Comment						
DS_ID:23749						
FS_ID:41810						
EP_NO: N/A						
Repair Type: Non-Urgent						
Crossing Status: Found						
UCIP Comments: Some silt buildup in pipe at LS toe.						
FIELD_STRUCT_DESC: 24-inch corrugated metal storm drainage pipe through the levee, 8 feet below the crown. Flap gate on the waterside (WS) end. Concrete U-shaped headwalls on both ends. Cobble grouted spillway across the berm. Cobble grouted apron on the landside (LS) end. [Additional Reference(s): DWR Levee Log, 1990. USACE San Joaquin O&M Manual 612.2, 1967, (HLM 10.97) and 612 (addendum), February 1999, (HLM 10.94) (Station 577+59)].						
FS Date: 5/21/2014

Headwall at LS toe.

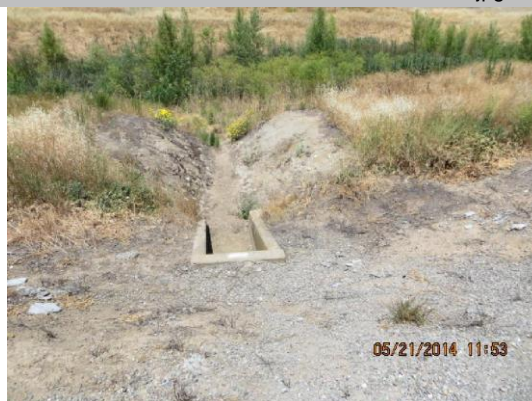
Photo 2 of 3 : UCIP_FA_2019_41810_69683.jpg

Headwall, flapgate, and grouted spillway on WS slope.

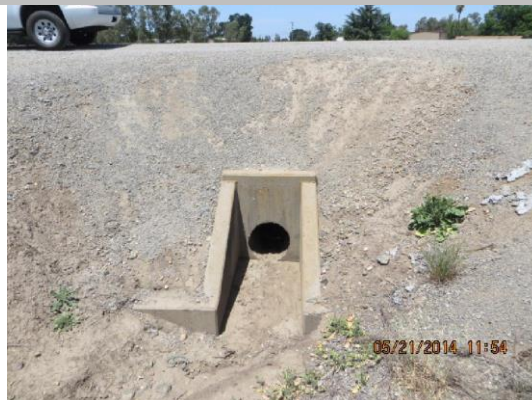
Photo 3 of 3 : UCIP_FA_2019_41810_69682.jpg

Headwall at LS toe.

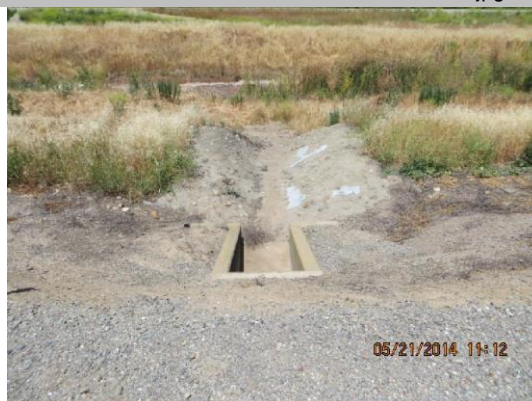
Photo 1 of 3 : UCIP_FA_2019_38224_69667.jpg

Headwall, flapgate, and grouted spillway on WS slope.

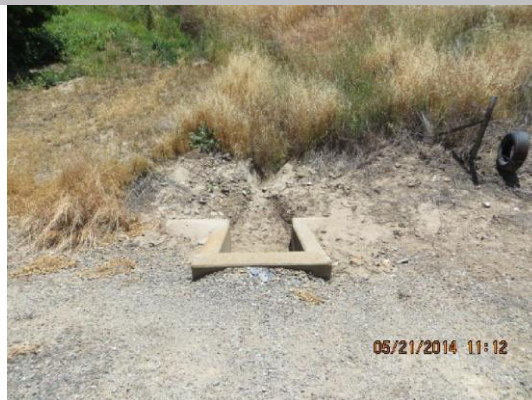
Photo 2 of 3 : UCIP_FA_2019_38224_69666.jpg

Headwall at LS toe.

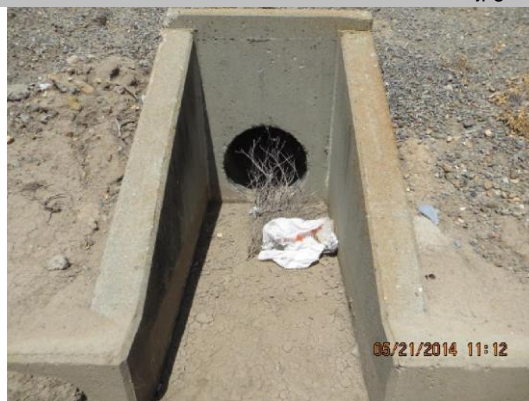
Photo 3 of 3 : UCIP_FA_2019_38224_69665.jpg

Headwall at LS toe.

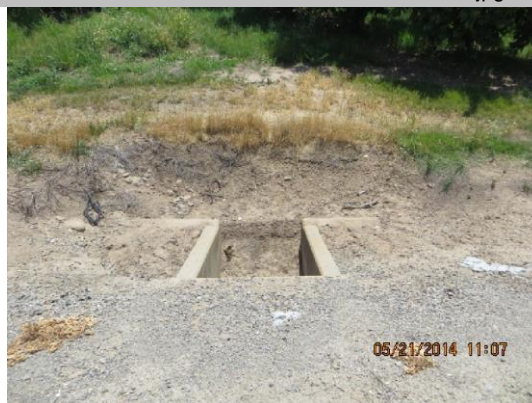
Photo 1 of 3 : UCIP_FA_2019_38223_69662.jpg

Headwall and grouted intake on LS toe.

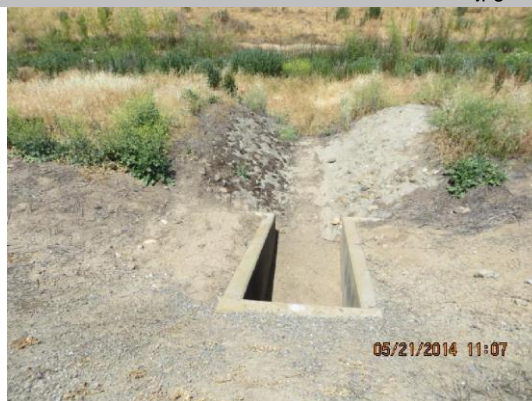
Photo 2 of 3 : UCIP_FA_2019_38223_69661.jpg

Headwall, flapgate, and grouted spillway on WS slope.

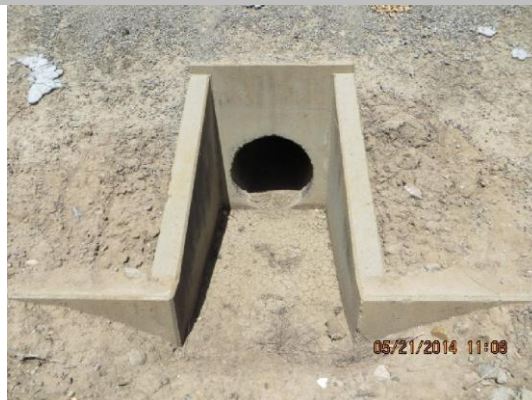
Photo 3 of 3 : UCIP_FA_2019_38223_69660.jpg

Headwall on LS toe.

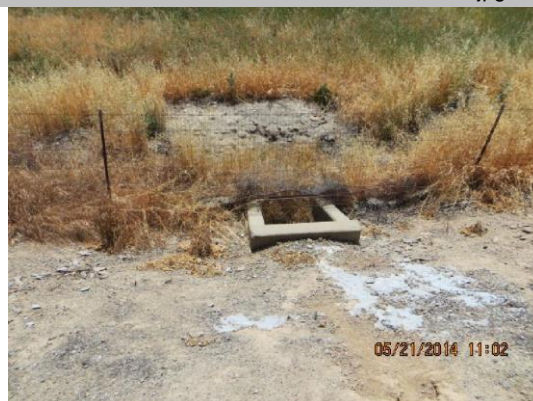
Photo 1 of 3 : UCIP_FA_2019_38221_69659.jpg

Headwall at LS toe with grouted inlet.

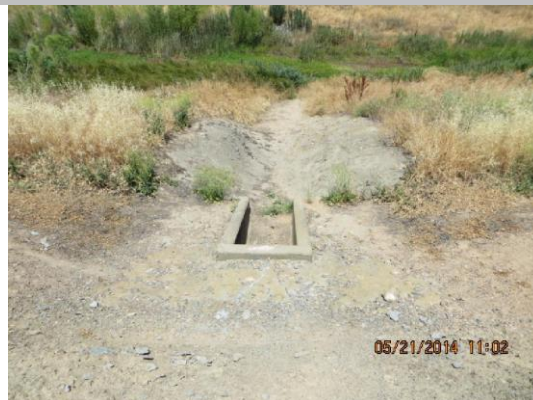
Photo 2 of 3 : UCIP_FA_2019_38221_69658.jpg

Headwall, flapgate, and grouted spillway on WS slope.

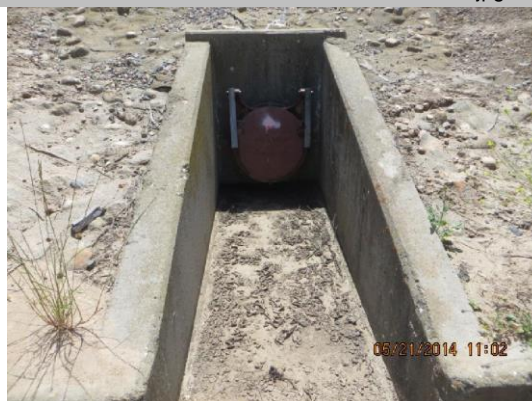
Photo 3 of 3 : UCIP_FA_2019_38221_69657.jpg

Headwall and flapgate on WS slope.

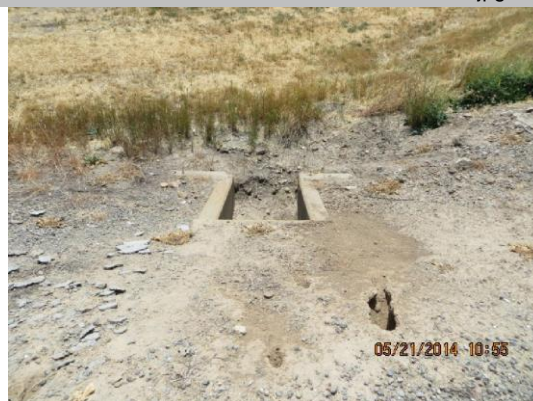
Photo 1 of 3 : UCIP_FA_2019_51700_69653.jpg

Headwall at LS toe.

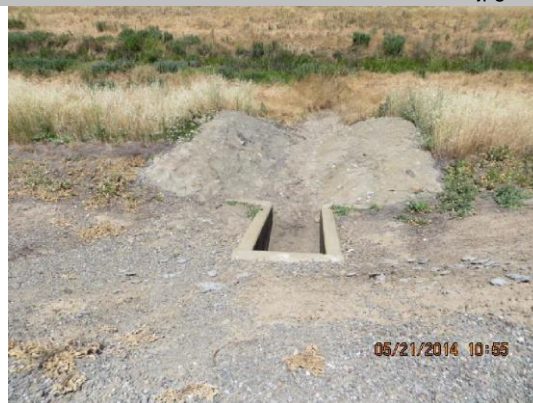
Photo 2 of 3 : UCIP_FA_2019_51700_69652.jpg

Headwall, flapgate, and grouted spillway on WS slope.

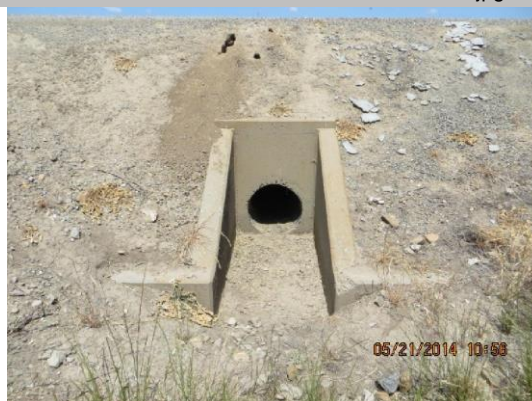
Photo 3 of 3 : UCIP_FA_2019_51700_69651.jpg

Headwall on LS toe.

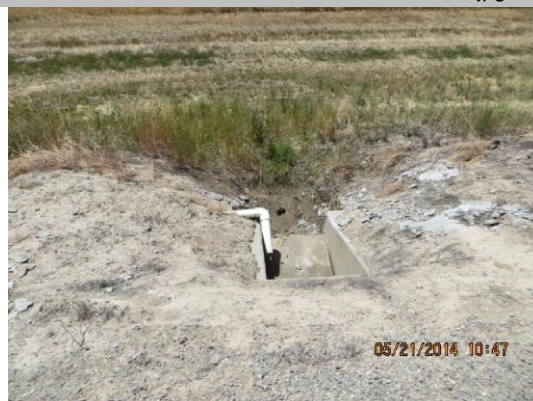
Photo 1 of 3 : UCIP_FA_2019_51701_69648.jpg

Headwall at LS toe. 4-inch PVC backwash from filter plant discharges at headwall.

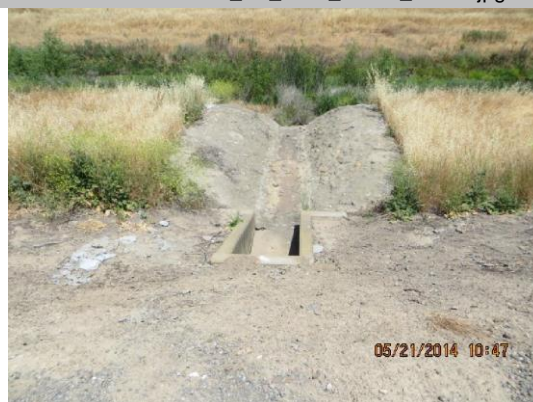
Photo 2 of 3 : UCIP_FA_2019_51701_69647.jpg

Headwall, flapgate, and grouted spillway on WS slope.

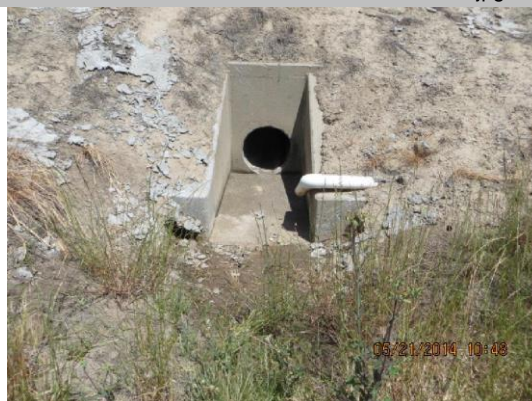
Photo 3 of 3 : UCIP_FA_2019_51701_69646.jpg

Item	DRAFT DWR UCIP LMA Responsibility			38.086137°	38.086137°	
				-121.190458°	-121.190458°	
DWR ID	23754					
Comment Code						
Inspector Comment						
DS_ID:23754 FS_ID:51701 EP_NO: N/A Repair Type: No Action Needed Crossing Status: Found UCIP Comments: 04/26/2017 Rodent activity is already accounted for via DWR FPIIB inspections. As per inspection chief G. Wylie, crossing has been downgraded from Non-Urgent to No Action Needed, as pipe integrity itself is not in question. (K. Fazel - UCIP)05/21/2014 Rodent activity at LS shoulder. (G. Wylie - FPIIB) FIELD_STRUCT_DESC: 24-inch corrugated metal drainage pipe through the levee, 7.5 feet below the crown. Flap gate on the waterside (WS) end. Concrete U-shaped headwalls on both ends. Cobble grouted spillway across the berm. Cobble grouted apron on the landside (LS) end. [Additional Reference(s): DWR Levee Log, 1990. USACE San Joaquin O&M Manual 612.2, 1967, (HLM 12.06)]. FS Date: 5/21/2014

Headwall on LS toe.

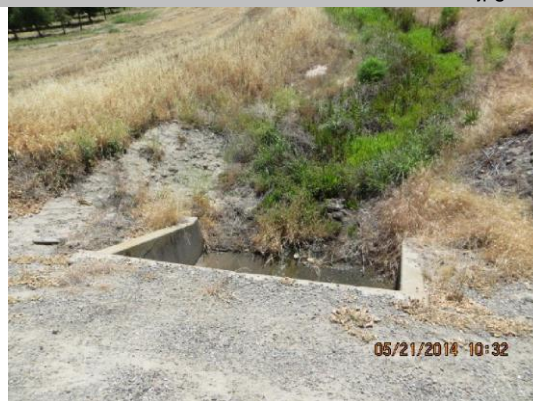
Photo 1 of 3 : UCIP_FA_2019_38216_69639.jpg

Comment Code						
Inspector Comment						
DS_ID:23756						
FS_ID:38216						
EP_NO: N/A						
Repair Type: Non-Urgent						
Crossing Status: Found						
UCIP Comments: CMP riser missing cover on WS slope.						
FIELD_STRUCT_DESC: 1 of 2: 48-inch corrugated metal storm drainage pipe through the levee, 8.5 feet below the crown. Slide gate in 60-inch corrugated metal riser unit on the waterside (WS) slope. Concrete U-shaped headwalls on both ends. Cobble grouted spillway on the WS end. Cobble grouted apron on the landside (LS) end.						
[Additional Reference(s): DWR Levee Log, 1990. USACE San Joaquin O&M Manual 612.2, 1967, (HLM 12.20) and 612 (addendum), February 1999, (HLM 12.13) (Station 640+50)].						
FS Date: 5/21/2014

Headwall on LS toe.

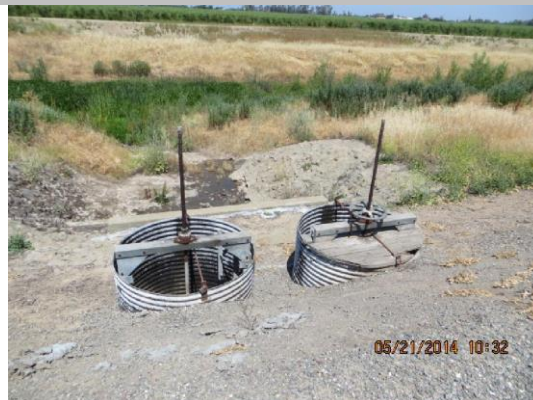
Photo 2 of 3 : UCIP_FA_2019_38216_69638.jpg

LM Start	11.84	Rating **	M	Issue No.	1169 (cont)
LM End	11.84	Issue Type +	Ma	Location *

Slide gate in CMP riser on WS slope missing cover.

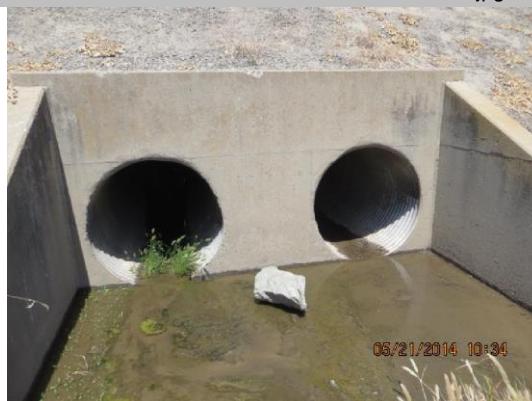
Photo 3 of 3 : UCIP_FA_2019_38216_69637.jpg

Item	DRAFT DWR UCIP LMA Responsibility			38.087303 °		38.087303 °
				-121.188608 °		-121.188608 °
DWR ID	23756					
Comment Code						
Inspector Comment						
DS_ID:23756						
FS_ID:38216						
EP_NO: N/A						
Repair Type: Non-Urgent						
Crossing Status: Found						
UCIP Comments: CMP riser missing cover on WS slope.						
FIELD_STRUCT_DESC: 1 of 2: 48-inch corrugated metal storm drainage pipe through the levee, 8.5 feet below the crown. Slide gate in 60-inch corrugated metal riser unit on the waterside (WS) slope. Concrete U-shaped headwalls on both ends. Cobble grouted spillway on the WS end. Cobble grouted apron on the landside (LS) end. [Additional Reference(s): DWR Levee Log, 1990. USACE San Joaquin O&M Manual 612.2, 1967, (HLM 12.20) and 612 (addendum), February 1999, (HLM 12.13) (Station 640+50)].						
FS Date: 5/21/2014

Headwall on LS toe.

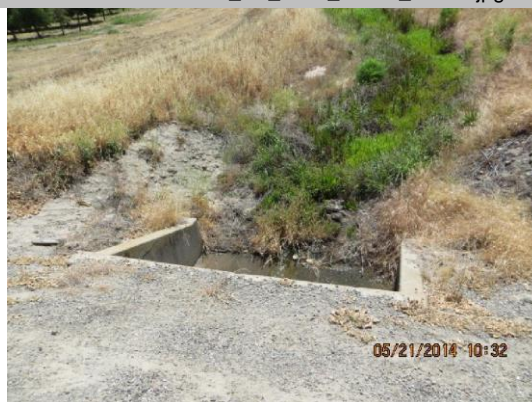
Photo 1 of 3 : UCIP_FA_2019_38214_69625.jpg

Comment Code						
Inspector Comment						
DS_ID:23818						
FS_ID:38214						
EP_NO: N/A						
Repair Type: Non-Urgent						
Crossing Status: Found						
UCIP Comments: CMP riser missing cover on WS slope may be hazard.						
FIELD_STRUCT_DESC: 2 of 2: 48-inch corrugated metal storm drainage pipe through the levee, 8.5 feet below the crown. Slide gate in 60-inch corrugated metal riser unit on the waterside (WS) slope. Concrete U-shaped headwalls on both ends. Cobble grouted spillway on the WS end. Cobble grouted apron on the landside (LS) end.						
[Additional Reference(s): DWR Levee Log, 1990. USACE San Joaquin O&M Manual 612.2, 1967, (HLM 12.20) and 612 (addendum), February 1999, (HLM 12.13) (Station 640+50)].						
FS Date: 5/21/2014

Headwall on LS toe.

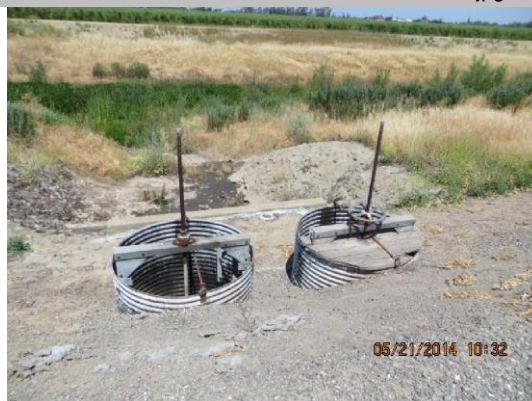
Photo 2 of 3 : UCIP_FA_2019_38214_69624.jpg

Item	DRAFT DWR UCIP LMA Responsibility			38.087319 °		38.087319 °
				-121.188596 °		-121.188596 °
DWR ID	23818					
Comment Code						
Inspector Comment						
DS_ID:23818						
FS_ID:38214						
EP_NO: N/A						
Repair Type: Non-Urgent						
Crossing Status: Found						
UCIP Comments: CMP riser missing cover on WS slope may be hazard.						
FIELD_STRUCT_DESC: 2 of 2: 48-inch corrugated metal storm drainage pipe through the levee, 8.5 feet below the crown. Slide gate in 60-inch corrugated metal riser unit on the waterside (WS) slope. Concrete U-shaped headwalls on both ends. Cobble grouted spillway on the WS end. Cobble grouted apron on the landside (LS) end. [Additional Reference(s): DWR Levee Log, 1990. USACE San Joaquin O&M Manual 612.2, 1967, (HLM 12.20) and 612 (addendum), February 1999, (HLM 12.13) (Station 640+50)].						
FS Date: 5/21/2014

Slidegate on WS shoulder.

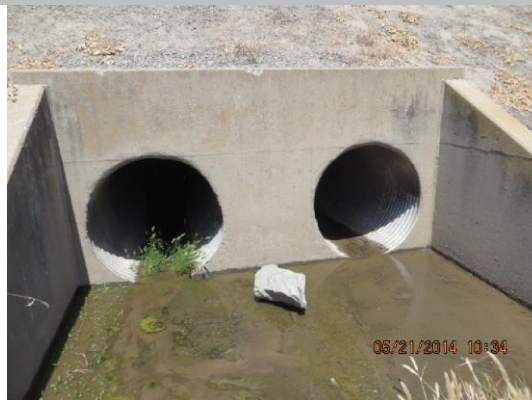
Photo 3 of 3 : UCIP_FA_2019_38214_69623.jpg

Headwall on LS toe.

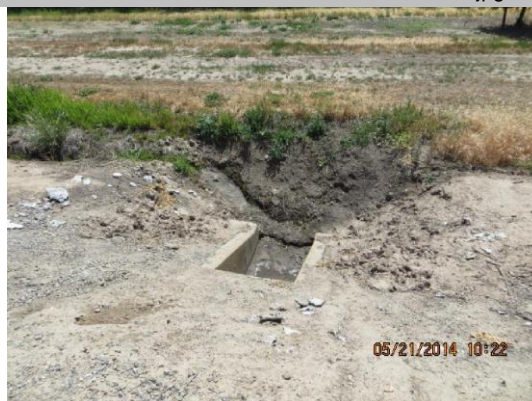
Photo 1 of 3 : UCIP_FA_2019_41811_69621.jpg

Comment Code					
Inspector Comment					
DS_ID:23757					
FS_ID:41811					
EP_NO: N/A					
Repair Type: Non-Urgent					
Crossing Status: Found					
UCIP Comments: Some sediment buildup in pipe at inlet.					
FIELD_STRUCT_DESC: 24-inch corrugated metal storm drainage pipe through the levee, 9 feet below the crown. Flap gate on the waterside (WS) end. Concrete U-shaped headwalls on both ends. Cobble grouted spillway across the berm. Cobble grouted apron on the landside (LS) end. [Additional Reference(s): DWR Levee Log, 1990. USACE San Joaquin O&M Manual 612.2, 1967, (HLM 12.43) and 612 (addendum), February 1999, (HLM 12.36) (Station 652+74)].					
FS Date: 5/21/2014

Headwall on LS toe.

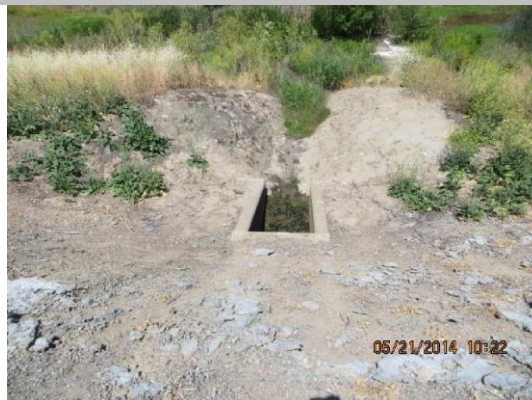
Photo 2 of 3 : UCIP_FA_2019_41811_69620.jpg

Headwall, flapgate, and grouted spillway on WS slope.

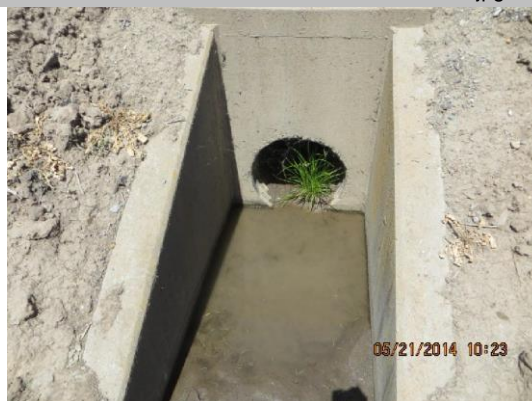
Photo 3 of 3 : UCIP_FA_2019_41811_69619.jpg

Item	DRAFT DWR UCIP LMA Responsibility			38.089088 °	38.089088 °	
				-121.185187 °	-121.185187 °	
DWR ID	23757					
Comment Code						
Inspector Comment						
DS_ID:23757 FS_ID:41811 EP_NO: N/A Repair Type: Non-Urgent Crossing Status: Found UCIP Comments: Some sediment buildup in pipe at inlet. FIELD_STRUCT_DESC: 24-inch corrugated metal storm drainage pipe through the levee, 9 feet below the crown. Flap gate on the waterside (WS) end. Concrete U-shaped headwalls on both ends. Cobble grouted spillway across the berm. Cobble grouted apron on the landside (LS) end. [Additional Reference(s): DWR Levee Log, 1990. USACE San Joaquin O&M Manual 612.2, 1967, (HLM 12.43) and 612 (addendum), February 1999, (HLM 12.36) (Station 652+74)]. FS Date: 5/21/2014

Headwall on LS toe.

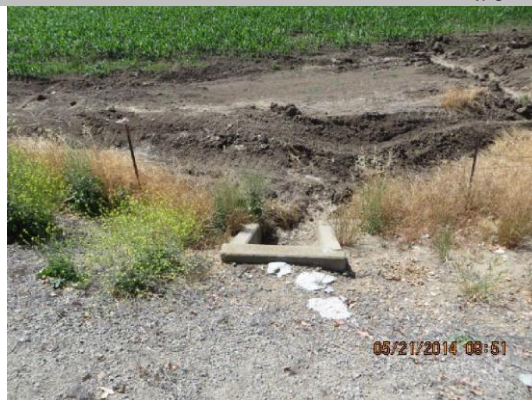
Photo 1 of 3 : UCIP_FA_2019_38210_69610.jpg

Comment Code						
Inspector Comment						
DS_ID:23761						
FS_ID:38210						
EP_NO: N/A						
Repair Type: No Action Needed						
Crossing Status: Found						
UCIP Comments:						
FIELD_STRUCT_DESC: 24-inch corrugated metal storm drainage pipe through the levee, 7.5 feet below the crown. Flap gate on the waterside (WS) end. Concrete U-shaped headwalls on both ends. Cobble grouted spillway across berm. Cobble grouted apron on the landside (LS) end. [Additional Reference(s): DWR Levee Log, 1990. USACE San Joaquin O&M Manual 612.2, 1967, (HLM 12.78) and 612 (addendum), February 1999, (HLM 12.70) (Station 670+43)].						
FS Date: 5/21/2014

Headwall on LS toe.

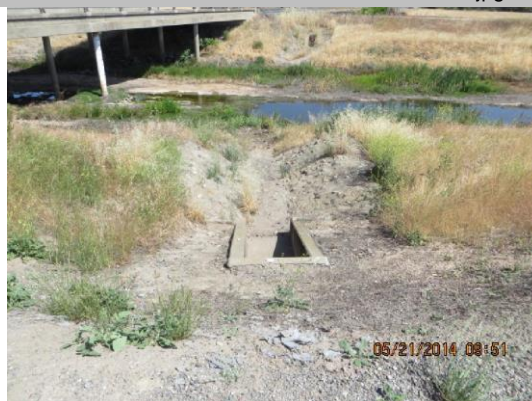
Photo 2 of 3 : UCIP_FA_2019_38210_69609.jpg

Headwall, flapgate, and grouted spillway on WS slope.

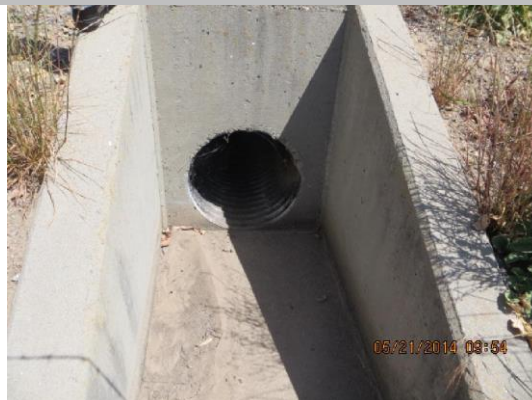
Photo 3 of 3 : UCIP_FA_2019_38210_69608.jpg

Headwall on LS toe.

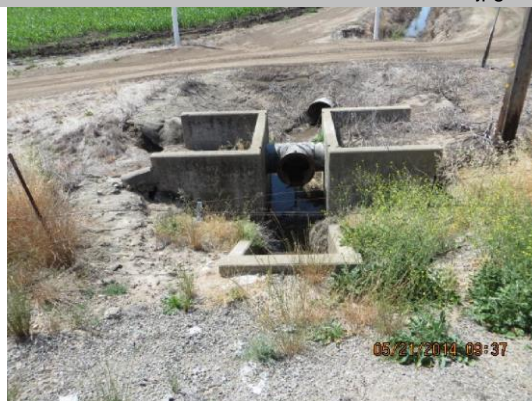
Photo 1 of 3 : UCIP_FA_2019_38206_69602.jpg

LM Start	12.57	Rating **	A/W	Issue No.	1176	
LM End	12.57	Issue Type +	Ma	Location *		
Category	Supplemental			GPS Latitude/Longitude		
				Start		End
Item	DRAFT DWR UCIP LMA Responsibility			38.092130 °		38.092130 °
				-121.178163 °		-121.178163 °
DWR ID	23764					
Comment Code						
Inspector Comment						
DS_ID:23764 FS_ID:38206 EP_NO: N/A Repair Type: No Action Needed Crossing Status: Found UCIP Comments: FIELD_STRUCT_DESC: 36-inch corrugated metal storm drainage pipe through the levee, 9 feet below the crown. Flap gate on the waterside (WS) end. Concrete U-shaped headwalls on both ends. Cobble grouted spillway on the WS end. Cobble grouted apron on the landside (LS) end. [Additional Reference(s): DWR Levee Log, 1990. USACE San Joaquin O&M Manual 612.2, 1967, (HLM 12.94) and 612 (addendum), February 1999, (HLM 12.86) (Station 678+88)]. FS Date: 5/21/2014

Headwall at LS toe next to irrigation structure.

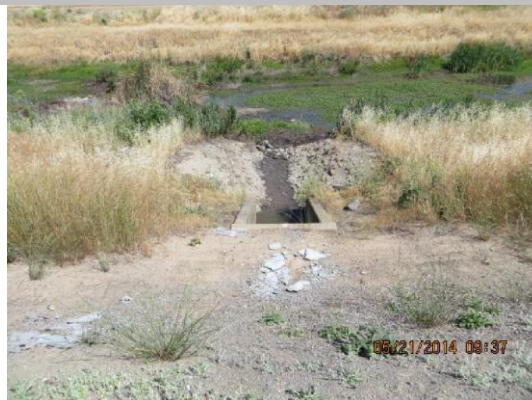
Photo 2 of 3 : UCIP_FA_2019_38206_69601.jpg

Headwall, flapgate, and grouted spillway on WS slope.

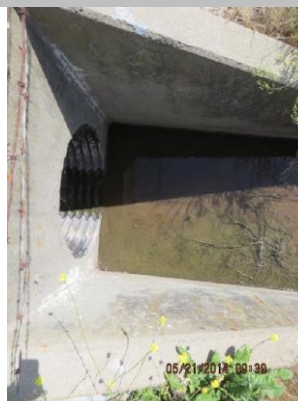
Photo 3 of 3 : UCIP_FA_2019_38206_69600.jpg

Headwall at LS toe.

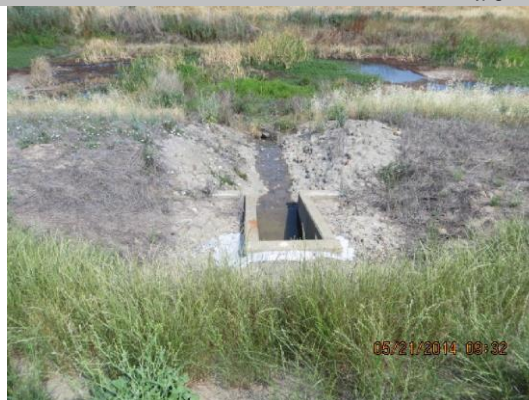
Photo 1 of 3 : UCIP_FA_2019_38205_69591.jpg

LM Start	12.63	Rating **	A/W	Issue No.	1177
LM End	12.63	Issue Type +	Ma	Location *	
Category	Supplemental			GPS Latitude/Longitude	
				Start	End
Item	DRAFT DWR UCIP LMA Responsibility			38.092598 °	38.092598 °
				-121.177228 °	-121.177228 °
DWR ID	23765				
Comment Code					
Inspector Comment					
DS_ID:23765					
FS_ID:38205					
EP_NO: N/A					
Repair Type: No Action Needed					
Crossing Status: Found					
UCIP Comments:					
FIELD_STRUCT_DESC: 24-inch corrugated metal drainage pipe through the levee, 9 feet below the crown. Flap gate on the waterside (WS) end. Slide gate on the landside (LS) end. Concrete U-shaped headwalls on both ends. Cobble grouted spillway across the berm. Cobble grouted apron on the LS end. [Additional Reference(s): DWR Levee Log, 1990. USACE San Joaquin O&M Manual 612.2, 1967, (HLM 13.00)].					
FS Date: 5/21/2014

Headwall, flapgate, and grouted spillway on WS slope.

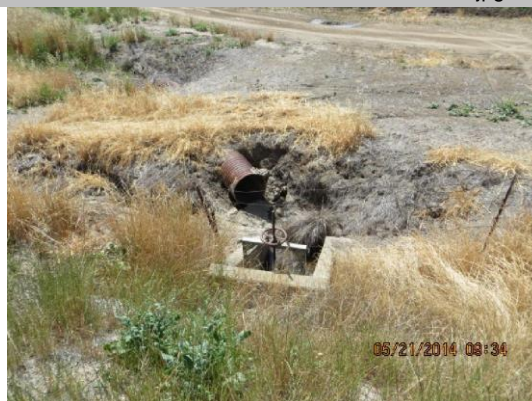
Photo 2 of 3 : UCIP_FA_2019_38205_69590.jpg

Headwall and Slidegate on LS toe.

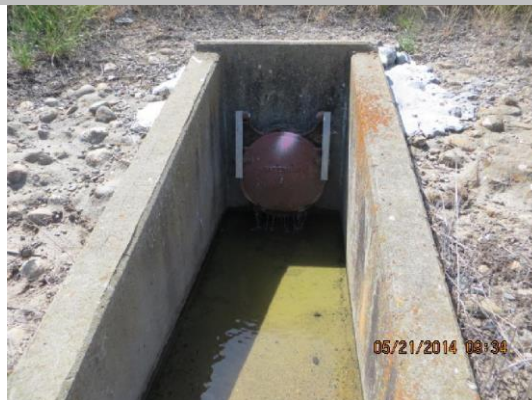
Photo 3 of 3 : UCIP_FA_2019_38205_69589.jpg

Headwall and Flapgate on WS slope.

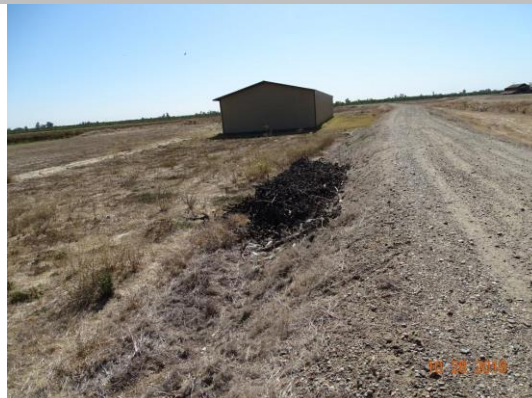
Photo 1 of 2 : FA_2019_NA0017_152_133_20191117_00311.jpg

LM Start	12.84	Rating **	M	Issue No.	133
LM End	12.84	Issue Type +	Ma	Location *	LS
Category	Earthen Levee			GPS Latitude/Longitude	
				Start	End
Item	Encroachments			38.096581°	38.096581°
				-121.175898°	-121.175898°
DWR ID	DWR_NA0017_08_s_2019_133				
Comment Code					
PR : Prunings					
Inspector Comment					
Prunings on landside toe.

View of prunings on landside slope. Fall 2019

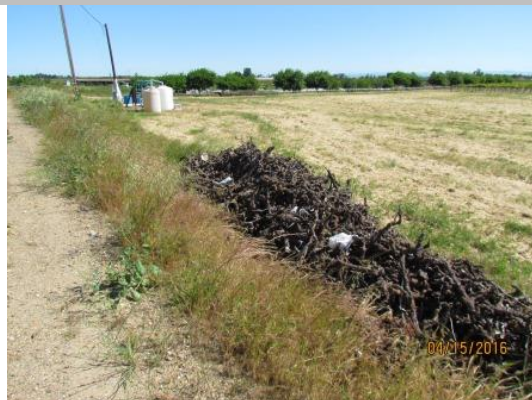
Photo 2 of 2 : FA_2019_NA0017_152_133_20190830_00024.jpg

View of prunings on the landside toe of the levee.

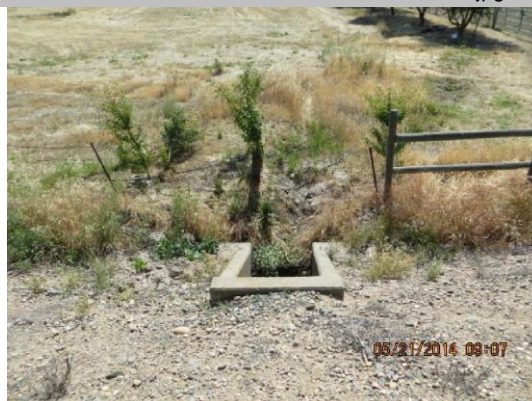
Photo 1 of 3 : UCIP_FA_2019_38203_69582.jpg

LM Start	12.89	Rating **	A/W	Issue No.	1179
LM End	12.89	Issue Type +	Ma	Location *	
Category	Supplemental			GPS Latitude/Longitude	
				Start	End
Item	DRAFT DWR UCIP LMA Responsibility			38.097279 °	38.097279 °
				-121.175854 °	-121.175854 °
DWR ID	23767				
Comment Code					
Inspector Comment					
DS_ID:23767					
FS_ID:38203					
EP_NO: N/A					
Repair Type: No Action Needed					
Crossing Status: Found					
UCIP Comments:					
FIELD_STRUCT_DESC: 24-inch corrugated metal drainage pipe through the levee, 7 feet below the crown. Concrete U-shaped headwall on both ends. Flap gate on the waterside (WS) end. Cobble grouted spillway. Cobble grouted intake on the landside (LS). [Additional Reference(s): DWR Levee Log, 1990. USACE San Joaquin O&M Manual 612.2, 1967, (HLM 13.26)].					
FS Date: 5/21/2014

Concrete headwall on LS toe.

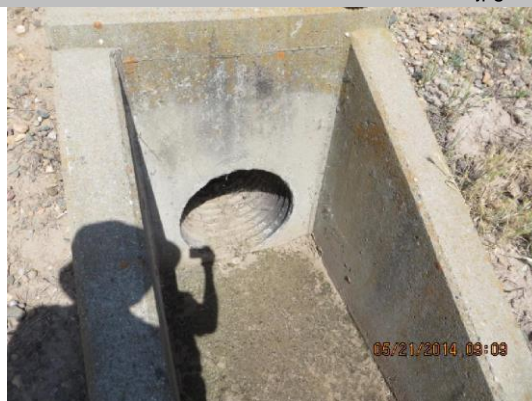
Photo 3 of 3 : UCIP_FA_2019_38203_69580.jpg

Concrete headwall on LS toe.

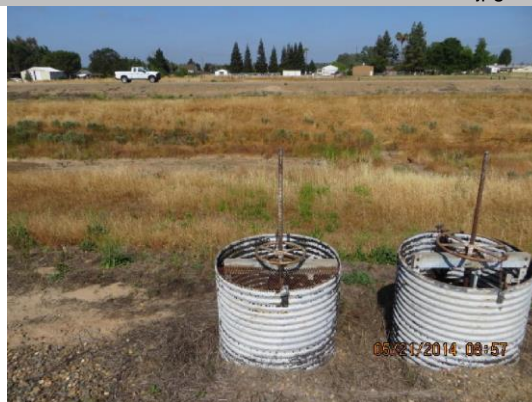
Photo 1 of 3 : UCIP_FA_2019_38144_69426.jpg

LM Start	12.98	Rating **	M	Issue No.	1180	
LM End	12.98	Issue Type +	Ma	Location *		
Category	Supplemental			GPS Latitude/Longitude		
				Start		End
Item	DRAFT DWR UCIP LMA Responsibility			38.098566 °		38.098566 °
				-121.175704 °		-121.175704 °
DWR ID	23768					
Comment Code						
Inspector Comment						
DS_ID:23768						
FS_ID:38144						
EP_NO: N/A						
Repair Type: Non-Urgent						
Crossing Status: Found						
UCIP Comments: Some debris buildup at inlet. No lid on CMP riser on WS slope.						
FIELD_STRUCT_DESC: 1 of 2: 36-inch corrugated metal drainage pipe through the levee, 10 feet below the crown. Concrete U-shaped headwall on both ends. Slide gate in corrugated metal riser unit on the waterside (WS) slope. Flap gate on the WS end. [Additional Reference(s): DWR Levee Log, 1990. USACE San Joaquin O&M Manual 612.2, 1967, (HLM 13.35)].						
FS Date: 5/21/2014

Slidegate in CMP riser on WS slope.

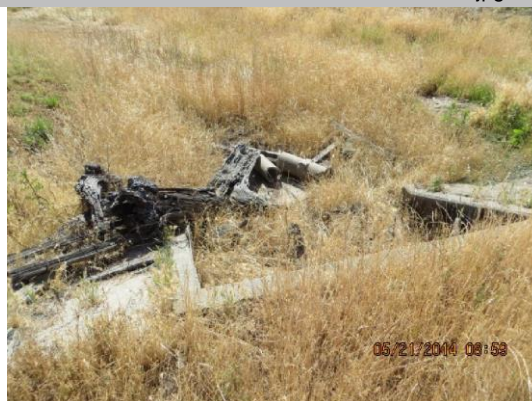
Photo 2 of 3 : UCIP_FA_2019_38144_69425.jpg

Headwall on LS toe. Note debris buildup.

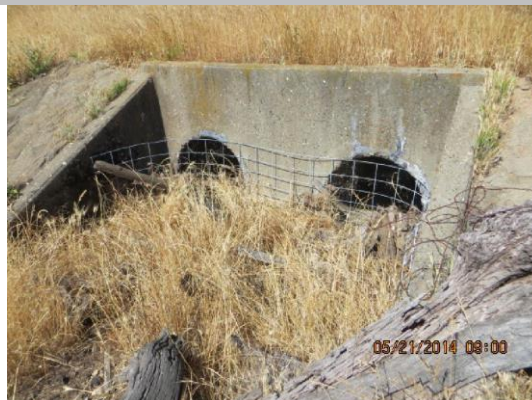
Photo 3 of 3 : UCIP_FA_2019_38144_69424.jpg

Headwall on LS toe. Note debris buildup.

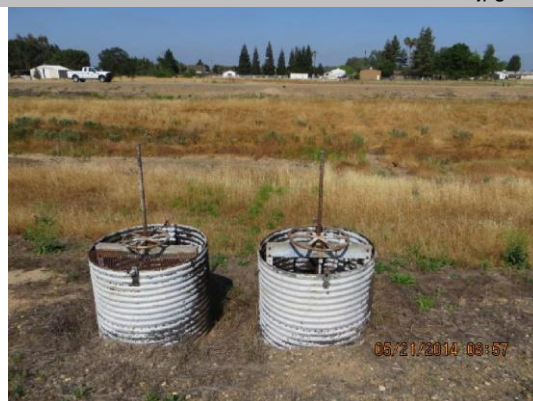
Photo 1 of 3 : UCIP_FA_2019_38143_69422.jpg

LM Start	12.98	Rating **	M	Issue No.	1181	
LM End	12.98	Issue Type +	Ma	Location *		
Category	Supplemental			GPS Latitude/Longitude		
				Start		End
Item	DRAFT DWR UCIP LMA Responsibility			38.098582 °		38.098582 °
				-121.175703 °		-121.175703 °
DWR ID	23816					
Comment Code						
Inspector Comment						
DS_ID:23816						
FS_ID:38143						
EP_NO: N/A						
Repair Type: Non-Urgent						
Crossing Status: Found						
UCIP Comments: Some debris buildup at inlet and no lid on standpipe at WS shoulder.						
FIELD_STRUCT_DESC: 2 of 2: 36-inch corrugated metal drainage pipe through the levee, 10 feet below the crown. Concrete U-shaped headwall on both ends. Slide gate in corrugated metal riser unit on the waterside (WS) slope. Flap gate on the WS end. [Additional Reference(s): DWR Levee Log, 1990. USACE San Joaquin O&M Manual 612.2, 1967, (HLM 13.35)].						
FS Date: 5/21/2014

Slide gate in CMP riser on WS slope.

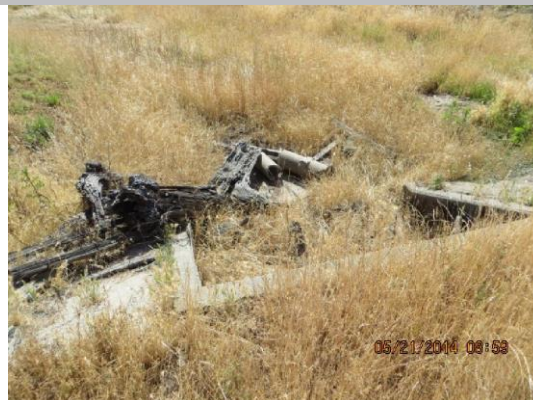
Photo 2 of 3 : UCIP_FA_2019_38143_69421.jpg

Headwall on LS toe. Note debris buildup.

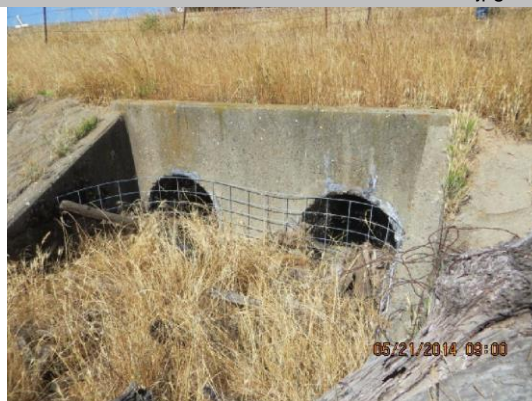
Photo 3 of 3 : UCIP_FA_2019_38143_69420.jpg

Headwall on LS toe. Note debris buildup.

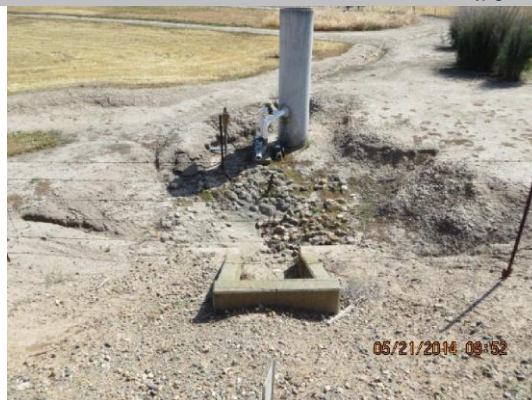
Photo 1 of 3 : UCIP_FA_2019_38141_69418.jpg

Headwall on LS toe.

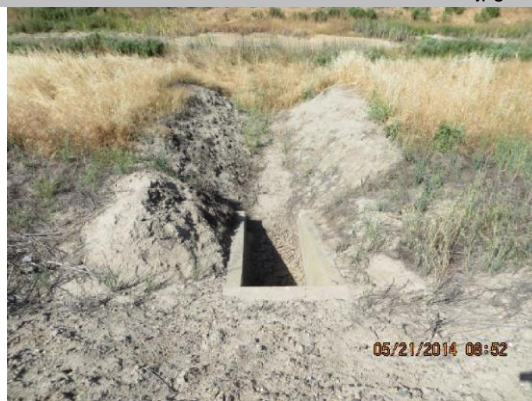
Photo 2 of 3 : UCIP_FA_2019_38141_69417.jpg

Headwall, flapgate, and grouted spillway on WS slope.

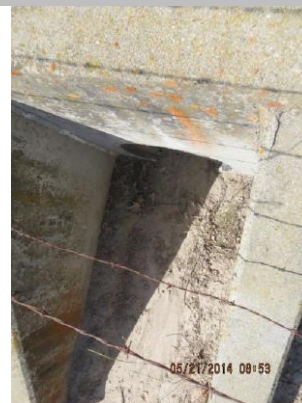
Photo 3 of 3 : UCIP_FA_2019_38141_69416.jpg

Headwall on LS toe.

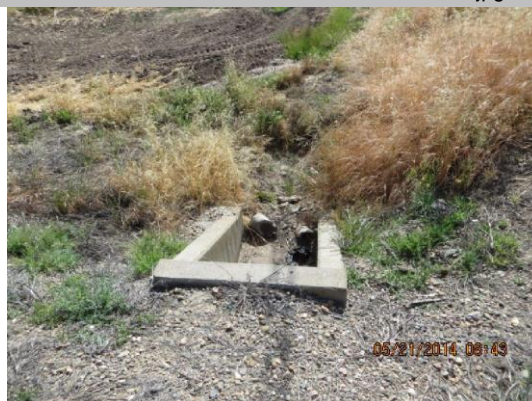
Photo 1 of 3 : UCIP_FA_2019_38140_69413.jpg

Headwall on LS toe.

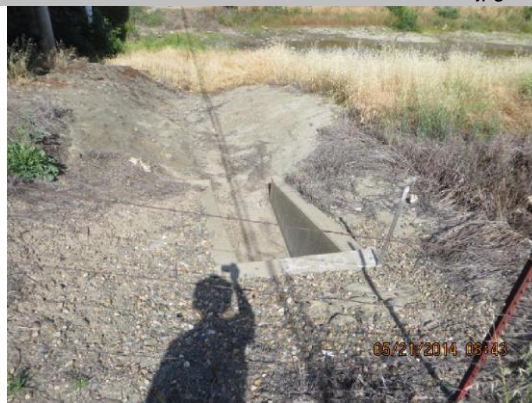
Photo 2 of 3 : UCIP_FA_2019_38140_69412.jpg

Headwall, flapgate, and grouted spillway on WS slope.

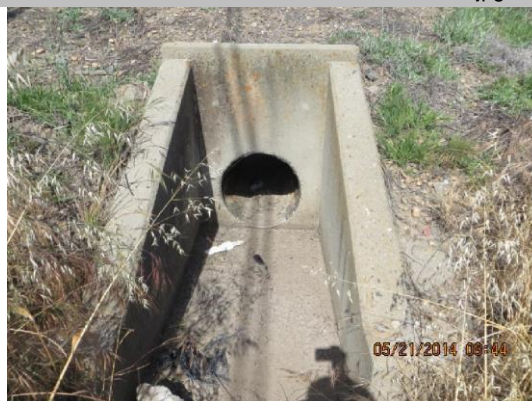
Photo 3 of 3 : UCIP_FA_2019_38140_69411.jpg

Headwall on LS toe.

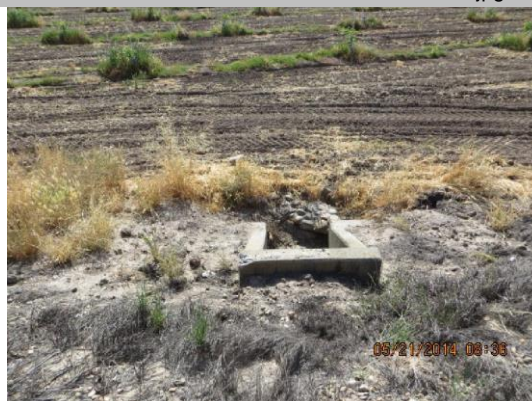
Photo 1 of 3 : UCIP_FA_2019_38139_69408.jpg

Headwall on LS toe.

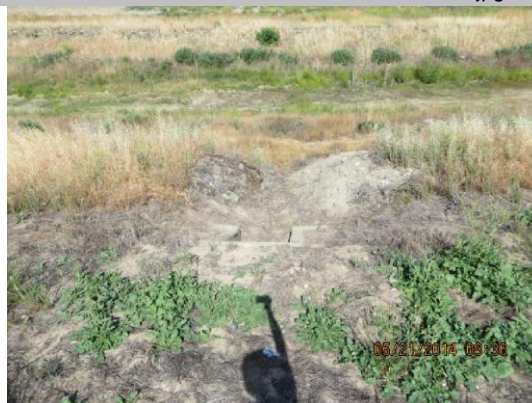
Photo 2 of 3 : UCIP_FA_2019_38139_69407.jpg

Headwall, flapgate, and grouted spillway on WS slope.

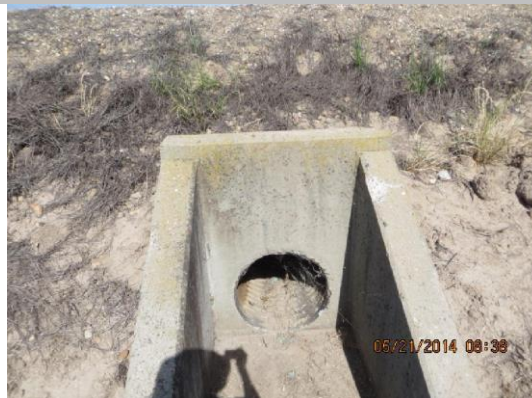
Photo 3 of 3 : UCIP_FA_2019_38139_69406.jpg

Headwall on LS toe.

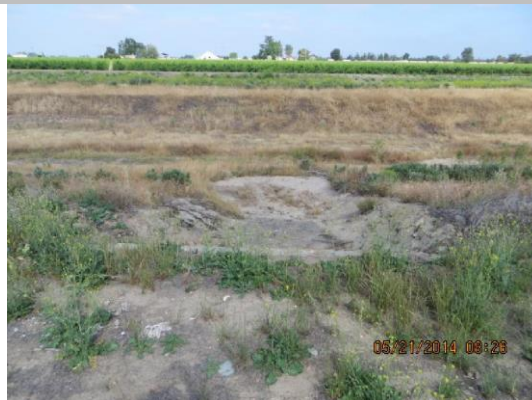
Photo 1 of 3 : UCIP_FA_2019_38137_69401.jpg

Headwall, flapgate, and grouted spillway on WS slope.

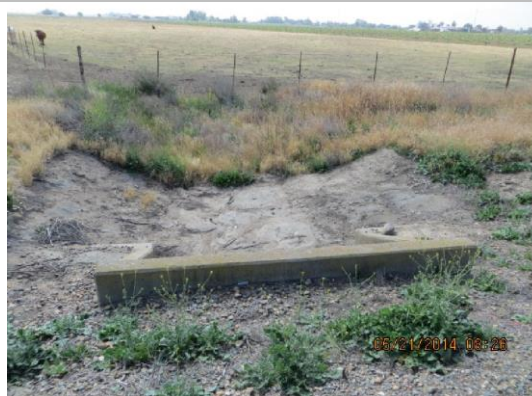
Photo 2 of 3 : UCIP_FA_2019_38137_69400.jpg

Headwall on LS toe.

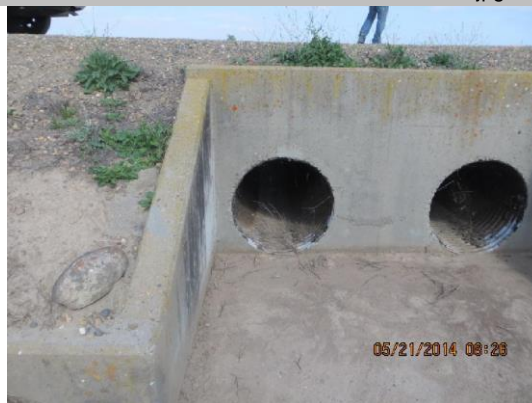
Photo 3 of 3 : UCIP_FA_2019_38137_69399.jpg

Headwall on LS toe.

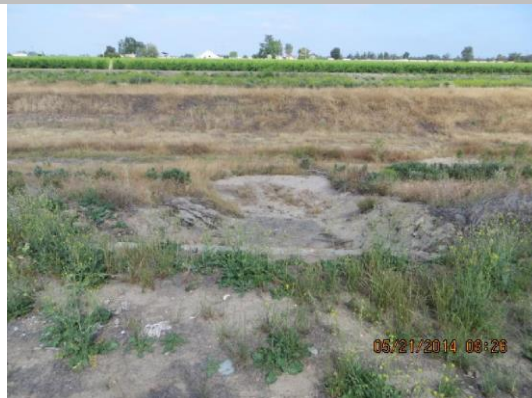
Photo 1 of 3 : UCIP_FA_2019_38136_69396.jpg

Headwall and flapgate on WS slope.

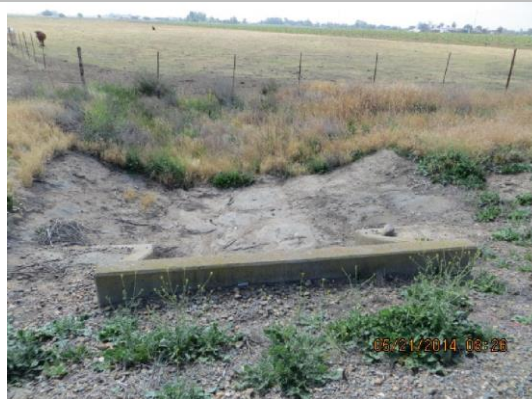
Photo 2 of 3 : UCIP_FA_2019_38136_69395.jpg

Headwall on LS toe.

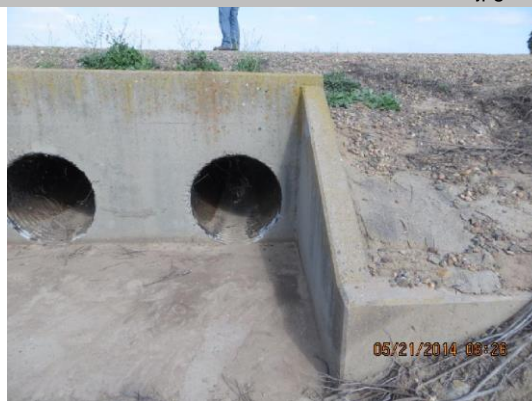
Photo 3 of 3 : UCIP_FA_2019_38136_69394.jpg

Headwall on LS toe.

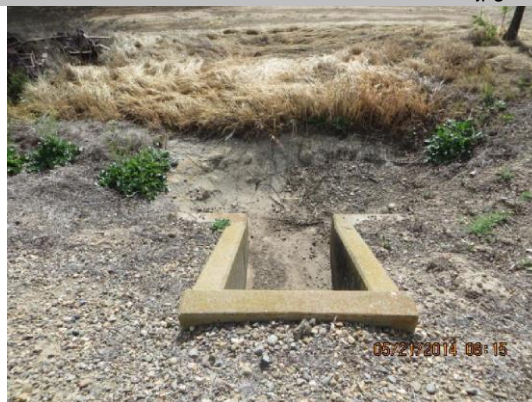
Photo 1 of 3 : UCIP_FA_2019_38134_69389.jpg

Headwall at LS toe.

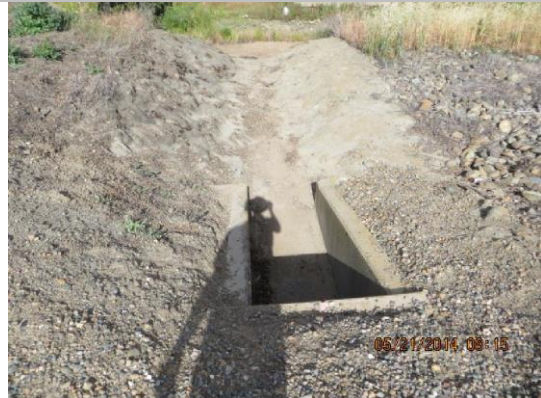
Photo 2 of 3 : UCIP_FA_2019_38134_69388.jpg

Headwall, flapgate, and grouted spillway on WS slope.

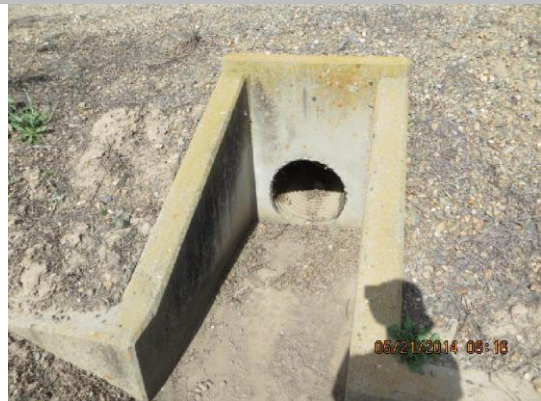
Photo 3 of 3 : UCIP_FA_2019_38134_69387.jpg

Headwall at LS toe.

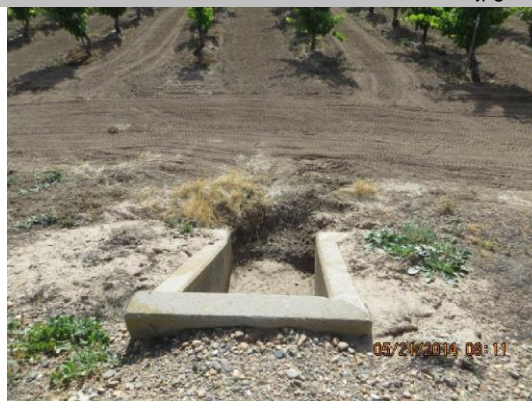
Photo 1 of 3 : UCIP_FA_2019_38133_69384.jpg

Headwall on LS toe.

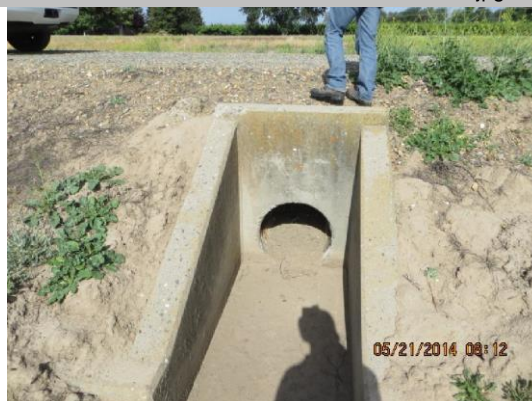
Photo 3 of 3 : UCIP_FA_2019_38133_69382.jpg

LM Start	14.08	Rating **	M	Issue No.	1189 (cont)	
LM End	14.08	Issue Type +	Ma	Location *		
Category	Supplemental			GPS Latitude/Longitude		
				Start	End	
Item	DRAFT DWR UCIP LMA Responsibility			38.112950 °	38.112950 °	
				-121.171992 °	-121.171992 °	
DWR ID	23776					
Comment Code						
Inspector Comment						
DS_ID:23776 FS_ID:38133 EP_NO: N/A Repair Type: Non-Urgent Crossing Status: Found UCIP Comments: Some silt buildup inside pipe. FIELD_STRUCT_DESC: 24-inch corrugated metal drainage pipe through the levee, 4 feet below the crown. Concrete U-shaped headwall on both ends. Flap gate on the waterside (WS) end. Cobble grouted spillway. Cobble grouted intake on the landside (LS). [Additional Reference(s): DWR Levee Log, 1990. USACE San Joaquin O&M Manual 612.2, 1967, (HLM 14.46)]. FS Date: 5/21/2014

Headwall on LS toe.

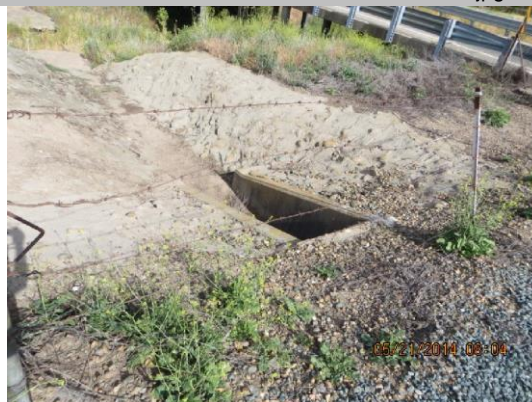
Photo 1 of 3 : UCIP_FA_2019_38130_69375.jpg

LM Start	14.31	Rating **	M	Issue No.	1190	
LM End	14.31	Issue Type +	Ma	Location *		
Category	Supplemental			GPS Latitude/Longitude		
				Start		End
Item	DRAFT DWR UCIP LMA Responsibility			38.116164 °		38.116164 °
				-121.171657 °		-121.171657 °
DWR ID	23778					
Comment Code						
Inspector Comment						
DS_ID:23778						
FS_ID:38130						
EP_NO: N/A						
Repair Type: Non-Urgent						
Crossing Status: Found						
UCIP Comments: Some silt buildup inside pipe.						
FIELD_STRUCT_DESC: 24-inch corrugated metal drainage pipe						
on both ends. Flap gate on the waterside (WS) end. Concrete U-shaped headwall						
spillway. Cobble grouted intake on the landside (LS). [Additional						
Reference(s): DWR Levee Log, 1990. USACE San Joaquin O&M						
Manual 612.2, 1967, (HLM 14.69)].						
FS Date: 5/21/2014

Headwall, flapgate, and grouted spillway on WS slope.
